**Flood Control Project Maintenance
Levee Inspections**

Fall 2019 Levee Maintenance Deficiency Summary Report

San Joaquin River Basin

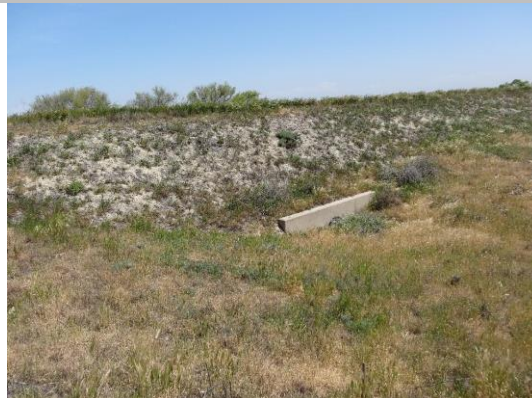
Photo 3 of 3 : UCIP_FA_2019_36609_66431.jpg

Comment Code						
Inspector Comment						
DS_ID:19831						
FS_ID:36609						
EP_NO: N/A						
Repair Type: Non-Urgent						
Crossing Status: Found						
UCIP Comments: 04/18/2014 Need to contact owner. Recommend removing tall grass on landward toe to determine condition of crossing from landward side. (DWR UCIP - O. Magana)						
FIELD_STRUCT_DESC: 24-inch corrugated metal gravity drainage pipe through the levee, 11.8 feet below the crown. Flap gate on the waterside (WS) end. Concrete headwall on each end. [Additional Reference(s): DWR Levee Log, 2002. USACE San Joaquin O&M Manual 601.1, 1967, (HLM 4.75)].						
FS Date: 4/18/2014

View of landward side.

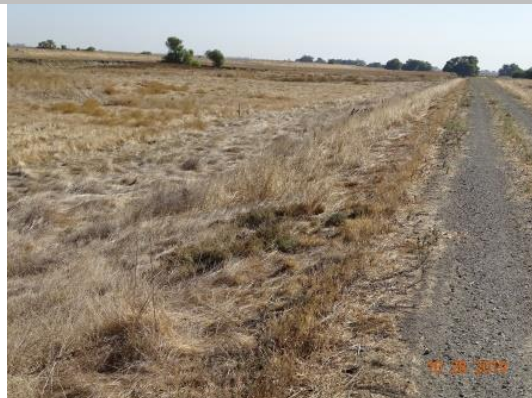
Photo 1 of 1 : FA_2019_NA0010_124_73_20191112_00195.jpg

LM Start	4.72	Rating **	U	Issue No.	73
LM End	5.78	Issue Type +	Ma	Location *	WS
Category	Earthen Levee			GPS Latitude/Longitude	
				Start	End
Item	Vegetation			37.243067°	37.238362°
				-120.759740°	-120.742356°
DWR ID	DWR_NA0010_06_f_2019_73				
Comment Code					
V1 : Control annual grass and weeds on the levee slopes and easements.					
Inspector Comment

View of the waterside slope looking upstream. (Fall 2019)

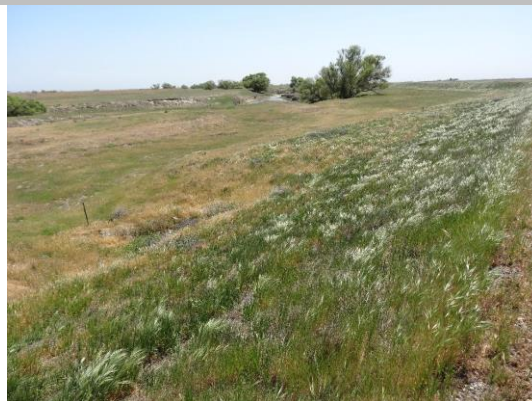
Photo 1 of 3 : UCIP_FA_2019_36610_66436.jpg

Comment Code						
Inspector Comment						
DS_ID:19862 FS_ID:36610 EP_NO: N/A Repair Type: Non-Urgent Crossing Status: Found UCIP Comments: 04/18/2014 Dense vegetation limits the inspector's visibility to identify signs of pipe failure (leaks) along the waterward slope. Recommend removing vegetation along waterward slope to conduct proper inspection of structure. Also recommend removing dense vegetation blocking landward headwall. (DWR UCIP - O. Magana) FIELD_STRUCT_DESC: 24-inch corrugated metal gravity drainage pipe through the levee, 10.8 feet below the crown. Flap gate on the waterside (WS) end. Concrete headwall on each end. [Additional Reference(s): DWR Levee Log, 2002. USACE San Joaquin O&M Manual 601.1, 1967, (HLM 4.94)]. FS Date: 4/18/2014

View of waterward side.

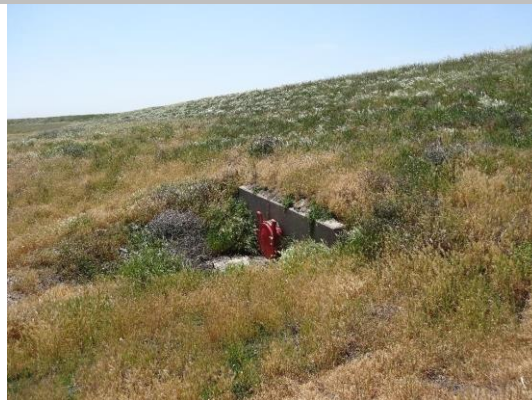
Photo 2 of 3 : UCIP_FA_2019_36610_66438.jpg

Comment Code						
Inspector Comment						
DS_ID:19862 FS_ID:36610 EP_NO: N/A Repair Type: Non-Urgent Crossing Status: Found UCIP Comments: 04/18/2014 Dense vegetation limits the inspector's visibility to identify signs of pipe failure (leaks) along the waterward slope. Recommend removing vegetation along waterward slope to conduct proper inspection of structure. Also recommend removing dense vegetation blocking landward headwall. (DWR UCIP - O. Magana) FIELD_STRUCT_DESC: 24-inch corrugated metal gravity drainage pipe through the levee, 10.8 feet below the crown. Flap gate on the waterside (WS) end. Concrete headwall on each end. [Additional Reference(s): DWR Levee Log, 2002. USACE San Joaquin O&M Manual 601.1, 1967, (HLM 4.94)]. FS Date: 4/18/2014

View of flap gate, concrete headwall and apron located on waterward side.

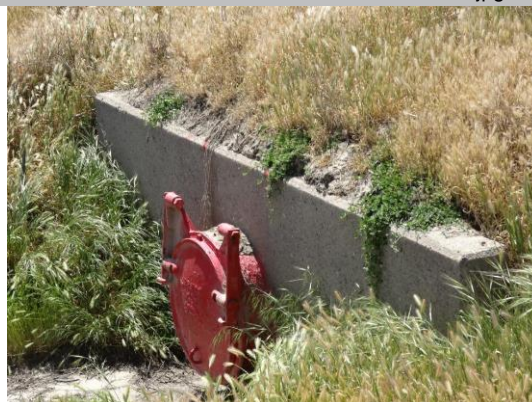
Photo 3 of 3 : UCIP_FA_2019_36610_66437.jpg

Close up of flap gate located on waterward side.

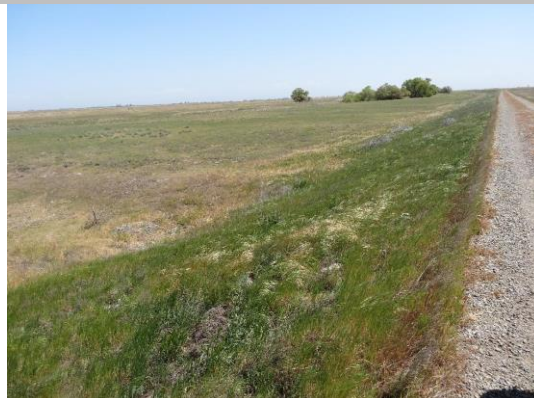
Photo 1 of 3 : UCIP_FA_2019_39875_61599.jpg

LM Start	5.26	Rating **	M	Issue No.	1230	
LM End	5.26	Issue Type +	Ma	Location *		
Category	Supplemental			GPS Latitude/Longitude		
				Start	End	
Item	DRAFT DWR UCIP LMA Responsibility			37.239098 °	37.239098 °	
				-120.751774 °	-120.751774 °	
DWR ID	19863					
Comment Code						
Inspector Comment						
DS_ID:19863						
FS_ID:39875						
EP_NO: N/A						
Repair Type: Non-Urgent						
Crossing Status: Found						
UCIP Comments: 04/18/2014 Clear vegetation from waterward slope and landward headwall. (DWR UCIP - O. Magana)						
FIELD_STRUCT_DESC: 24-inch corrugated metal gravity drainage pipe through the levee, 10.9 feet below the crown. Flap gate on the waterside (WS) end. Concrete headwall on each end. [Additional Reference(s): DWR Levee Log, 2002. USACE San Joaquin O&M Manual 601.1, 1967, (HLM 5.34)].						
FS Date: 4/18/2014

View of waterward side.

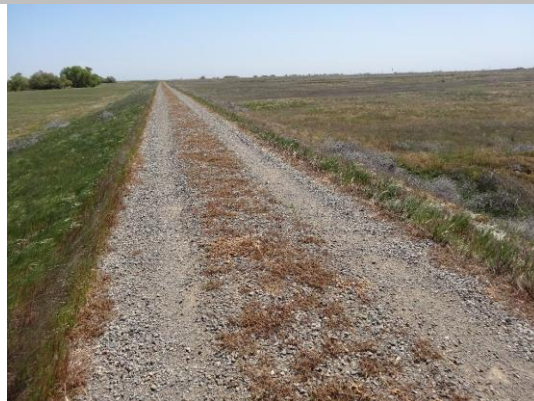
Photo 2 of 3 : UCIP_FA_2019_39875_61598.jpg

Overview of levee crown at crossing.

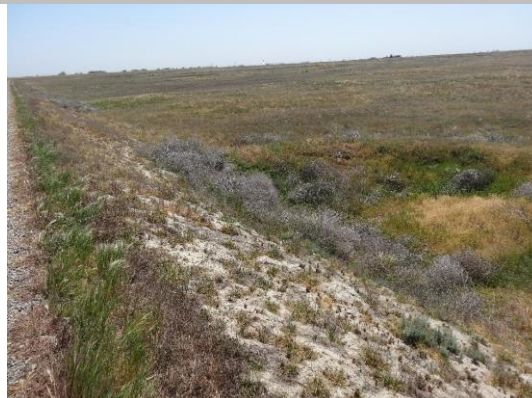
Photo 3 of 3 : UCIP_FA_2019_39875_61597.jpg

LM Start	5.26	Rating **	M	Issue No.	1230 (cont)	
LM End	5.26	Issue Type +	Ma	Location *		
Category	Supplemental			GPS Latitude/Longitude		
				Start	End	
Item	DRAFT DWR UCIP LMA Responsibility			37.239098 °	37.239098 °	
				-120.751774 °	-120.751774 °	
DWR ID	19863					
Comment Code						
Inspector Comment						
DS_ID:19863 FS_ID:39875 EP_NO: N/A Repair Type: Non-Urgent Crossing Status: Found UCIP Comments: 04/18/2014 Clear vegetation from waterward slope and landward headwall. (DWR UCIP - O. Magana) FIELD_STRUCT_DESC: 24-inch corrugated metal gravity drainage pipe through the levee, 10.9 feet below the crown. Flap gate on the waterside (WS) end. Concrete headwall on each end. [Additional Reference(s): DWR Levee Log, 2002. USACE San Joaquin O&M Manual 601.1, 1967, (HLM 5.34)]. FS Date: 4/18/2014

View of landward side.

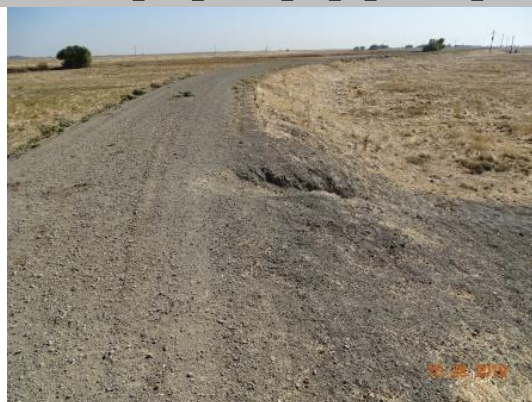
Photo 1 of 2 : FA_2019_NA0010_124_66_20191112_00196.jpg

LM Start	5.81	Rating **	M	Issue No.	66
LM End	5.81	Issue Type +	Ma	Location *	LS
Category	Earthen Levee			GPS Latitude/Longitude	
				Start	End
Item	Slope Stability			37.238189 °	37.238189 °
				-120.741946 °	-120.741946 °
DWR ID	DWR_NA0010_06_f_2017_66				
Comment Code					
S2 : Repair the levee slope damaged by foot traffic and prevent access where possible.					
Inspector Comment					
There is damage to the landside slope and shoulder from livestock.

View of damage to landside slope from livestock traffic looking downstream. (Fall 2019)

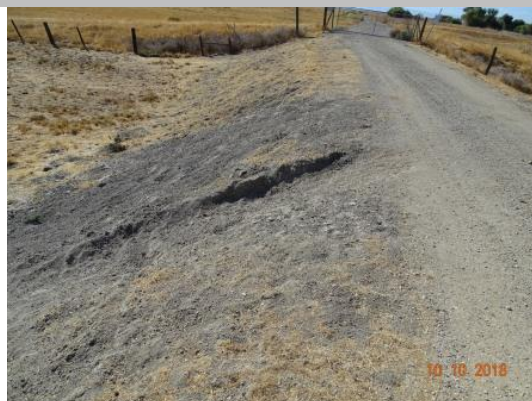
Photo 2 of 2 : FA_2019_NA0010_124_66_20190912_00012.jpg

LM Start	5.81	Rating **	M	Issue No.	66 (cont)	
LM End	5.81	Issue Type +	Ma	Location *	LS	
Category	Earthen Levee			GPS Latitude/Longitude		
				Start		End
Item	Slope Stability			37.238189 °		37.238189 °
				-120.741946 °		-120.741946 °
DWR ID	DWR_NA0010_06_f_2017_66					
Comment Code						
S2 : Repair the levee slope damaged by foot traffic and prevent access where possible.						
Inspector Comment						
There is damage to the landside slope and shoulder from livestock.

Damage from livestock. (Fall 2018)

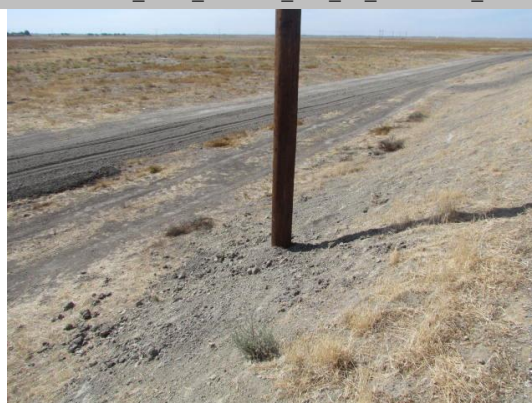
Photo 1 of 2 : FA_2019_NA0010_124_69_20190912_00015.jpg

LM Start	5.93	Rating **	M	Issue No.	69
LM End	6.25	Issue Type +	En	Location *	LS
Category	Earthen Levee			GPS Latitude/Longitude	
				Start	End
Item	Encroachments			37.236936 °	37.235487 °
				-120.740384 °	-120.737685 °
DWR ID	DWR_NA0010_06_f_2015_69				
Comment Code					
PO : Pole					
Inspector Comment					
There are several PG&E poles within this section at the landside toe and slope.

Looking at power pole on landward slope.

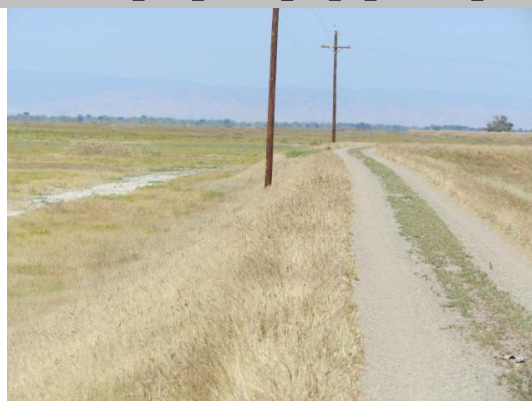
Photo 2 of 2 : FA_2019_NA0010_124_69_20190912_00016.jpg

Looking west at several PG&E poles on landward slope.

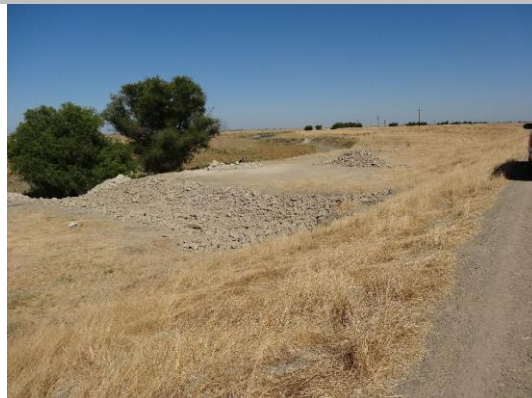
Photo 1 of 3 : UCIP_FA_2019_51312_75493.jpg

Comment Code						
Inspector Comment						
DS_ID:19865 FS_ID:51312 EP_NO: N/A Repair Type: No Action Needed Crossing Status: Found UCIP Comments: 7/19/2016 Site has been repaired on WS and LS (see photos below). (DWR UCIP - omagana)5/26/2016 Erosion is undermining the WS headwall of drainage structure (photos of WS headwall provided by DWR Inspector R. Willoughby). Potential pipe failure at the outlet just behind headwall, recommend completing internal wall integrity of pipe length through levee to determine extent of damage to pipe. (DWR UCIP - omagana)4/18/2014 Need to contact owner. Sediment buildup in pipe visible on landside--recommend clearing. (DWR UCIP - omagana) FIELD_STRUCT_DESC: 24-inch corrugated metal gravity drainage pipe through the levee, 9 feet below the crown. Flap gate on the waterside (WS) end. Concrete headwall on each end. [Additional Reference(s): DWR Levee Log, 2002. USACE San Joaquin O&M Manual 601.1, 1967, (HLM 6.06)]. FS Date: 7/19/2016

View of WS--rock protection along drainage path.

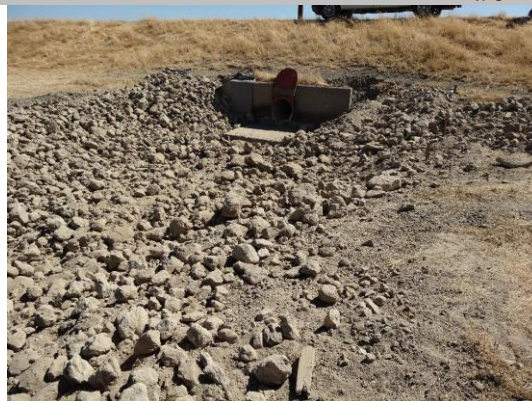
Photo 2 of 3 : UCIP_FA_2019_51312_75488.jpg

WS drainage path protected by rip rap.

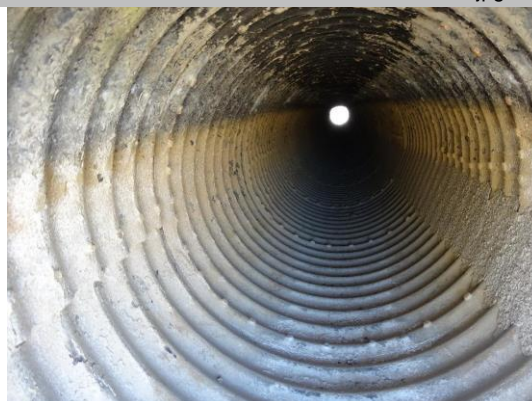
Photo 3 of 3 : UCIP_FA_2019_51312_75489.jpg

Inside view of pipe from WS.

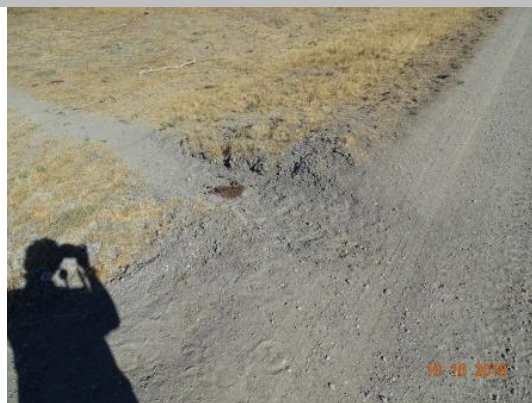
Photo 1 of 1 : FA_2019_NA0010_124_85_20190912_00029.jpg

LM Start	6.09	Rating **	M	Issue No.	85
LM End	6.09	Issue Type +	Ma	Location *	WS
Category	Earthen Levee			GPS Latitude/Longitude	
				Start	End
Item	Slope Stability			37.235572 °	37.235572 °
				-120.738002 °	-120.738002 °
DWR ID	DWR_NA0010_06_f _ 2018_85				
Comment Code					
S2 : Repair the levee slope damaged by foot traffic and prevent access where possible.					
Inspector Comment					
Livestock damage to slope and shoulder of levee.

View of livestock damage on waterside slope. (Fall 2018)

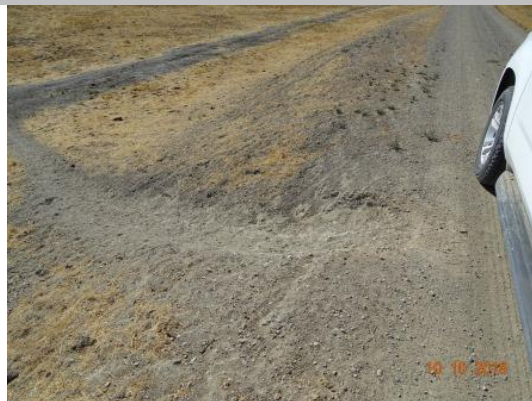
Photo 1 of 1 : FA_2019_NA0010_124_84_20190912_00028.jpg

LM Start	6.10	Rating **	A/W	Issue No.	84
LM End	6.10	Issue Type +	Ma	Location *	LS
Category	Earthen Levee			GPS Latitude/Longitude	
				Start	End
Item	Slope Stability			37.235570 °	37.235570 °
				-120.737998 °	-120.737998 °
DWR ID	DWR_NA0010_06_f _ 2018_84				
Comment Code					
S2 : Repair the levee slope damaged by foot traffic and prevent access where possible.					
Inspector Comment					
Damage to slope and crown from livestock.

Erosion to slope and into crown from livestock. (Fall 2018)

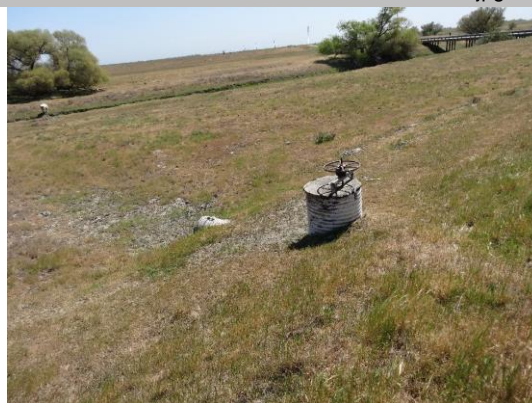
Photo 1 of 3 : UCIP_FA_2019_33984_61628.jpg

LM Start	6.70	Rating **	A/W	Issue No.	1233	
LM End	6.70	Issue Type +	Ma	Location *		
Category	Supplemental			GPS Latitude/Longitude		
				Start	End	
Item	DRAFT DWR UCIP LMA Responsibility			37.230508 °	37.230508 °	
				-120.729634 °	-120.729634 °	
DWR ID	19866					
Comment Code						
Inspector Comment						
DS_ID:19866						
FS_ID:33984						
EP_NO: N/A						
Repair Type: No Action Needed						
Crossing Status: Found						
UCIP Comments:						
FIELD_STRUCT_DESC: 24-inch corrugated metal gravity drainage pipe through the levee, 7 feet below the crown. Slide gate in a 36-inch corrugated metal pipe (CMP) riser on the waterside (WS) slope. Concrete headwall on the landside (LS) end. Concrete saddle and apron on the WS end. [Additional Reference(s): DWR Levee Log, 2002. USACE San Joaquin O&M Manual 601.1, 1967, (HLM 6.79)].						
FS Date: 4/18/2014

Slide gate inside CMP riser and pipe visible on waterward side.

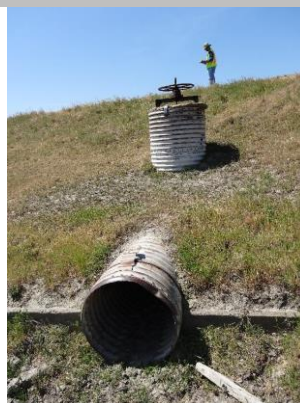
Photo 2 of 3 : UCIP_FA_2019_33984_61627.jpg

Concrete headwall visible on waterward side.

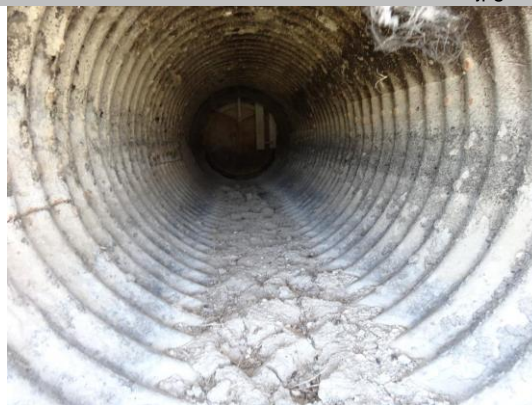
Photo 3 of 3 : UCIP_FA_2019_33984_61626.jpg

Inside view pipe from waterward side.

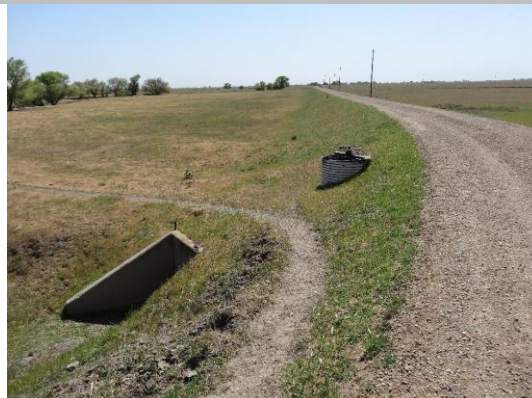
Photo 1 of 3 : UCIP_FA_2019_33985_61640.jpg

LM Start	6.89	Rating **	A/W	Issue No.	1234
LM End	6.89	Issue Type +	Ma	Location *	
Category	Supplemental			GPS Latitude/Longitude	
				Start	End
Item	DRAFT DWR UCIP LMA Responsibility			37.228253 °	37.228253 °
				-120.727865 °	-120.727865 °
DWR ID	19867				
Comment Code					
Inspector Comment					
DS_ID:19867					
FS_ID:33985					
EP_NO: N/A					
Repair Type: No Action Needed					
Crossing Status: Found					
UCIP Comments:					
FIELD_STRUCT_DESC: 36-inch corrugated metal gravity drainage pipe through the levee, 10.7 feet below the crown. Slide gate in a 48-inch corrugated metal pipe (CMP) riser on the waterside (WS) slope. Concrete headwall on the landside (LS) end. Concrete U-shaped headwall on the WS end. [Additional Reference(s): DWR Levee Log, 2002. USACE San Joaquin O&M Manual 601.1, 1967, (HLM 6.97)].					
FS Date: 4/18/2014

View of waterward side.

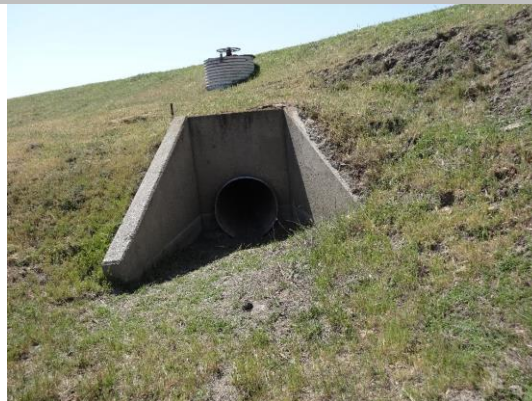
Photo 2 of 3 : UCIP_FA_2019_33985_61639.jpg

Concrete headwall and CMP riser visible on waterward side.

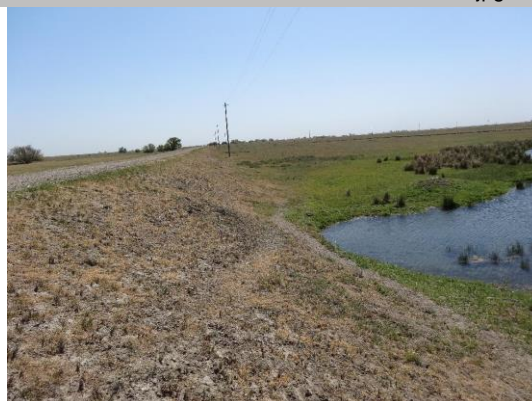
Photo 3 of 3 : UCIP_FA_2019_33985_61638.jpg

View of landward side.

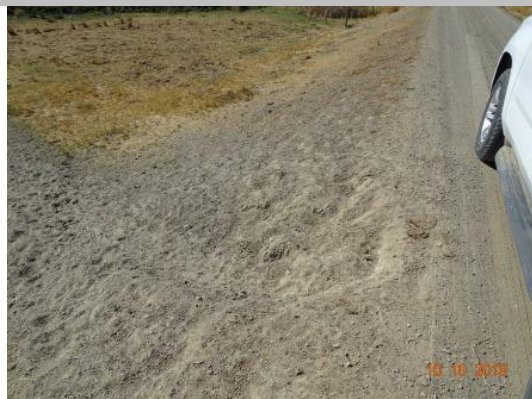
Photo 1 of 1 : FA_2019_NA0010_124_79_20190912_00023.jpg

LM Start	6.92	Rating **	A/W	Issue No.	79
LM End	6.92	Issue Type +	Ma	Location *	LS
Category	Earthen Levee			GPS Latitude/Longitude	
				Start	End
Item	Slope Stability			37.228054°	37.228054°
				-120.727428°	-120.727428°
DWR ID	DWR_NA0010_06_f_2018_79				
Comment Code					
S2 : Repair the levee slope damaged by foot traffic and prevent access where possible.					
Inspector Comment					
There is livestock damage to slope and shoulder of levee.

Damage to slope and shoulder from livestock. (Fall 2018)

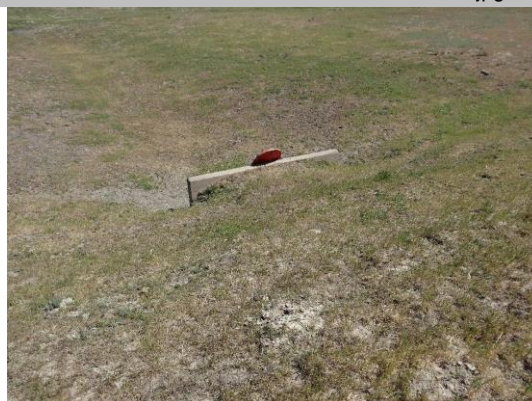
Photo 1 of 3 : UCIP_FA_2019_39471_61650.jpg

LM Start	7.21	Rating **	M	Issue No.	1235	
LM End	7.21	Issue Type +	Ma	Location *		
Category	Supplemental			GPS Latitude/Longitude		
				Start		End
Item	DRAFT DWR UCIP LMA Responsibility			37.226102 °		37.226102 °
				-120.722739 °		-120.722739 °
DWR ID	19868					
Comment Code						
Inspector Comment						
DS_ID:19868 FS_ID:39471 EP_NO: N/A Repair Type: Non-Urgent Crossing Status: Found UCIP Comments: 04/18/2014 Need to contact owner. Clear animal from waterward side. Some sediment buildup in pipe visible landward side--recommend clearing. (DWR UCIP - O. Magana) FIELD_STRUCT_DESC: 24-inch corrugated metal gravity drainage pipe through the levee, 10.6 feet below the crown. Flap gate on the waterside (WS) end. Concrete headwall on each end. [Additional Reference(s): DWR Levee Log, 2002. USACE San Joaquin O&M Manual 601.1, 1967, (HLM 7.29)]. FS Date: 4/18/2014

View of waterward side.

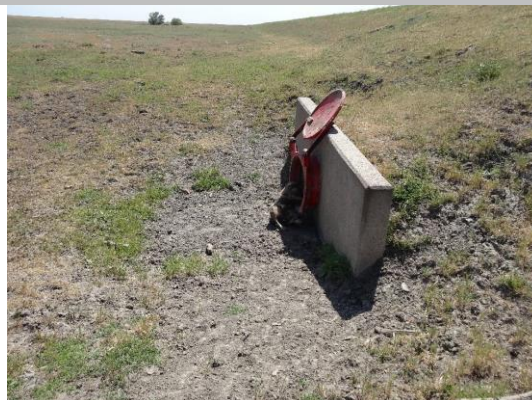
Photo 2 of 3 : UCIP_FA_2019_39471_61649.jpg

Concrete headwall and flap gate visible on waterward side. Dead animal inside pipe.

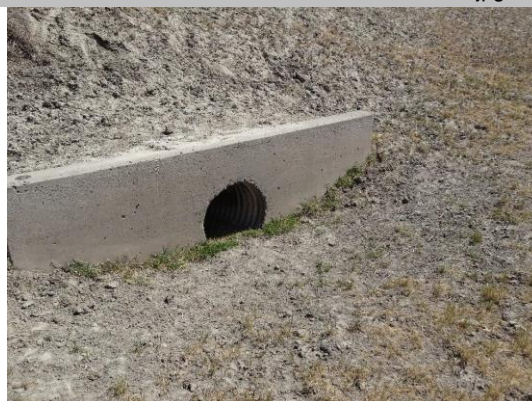
Photo 3 of 3 : UCIP_FA_2019_39471_61648.jpg

View of landward side.

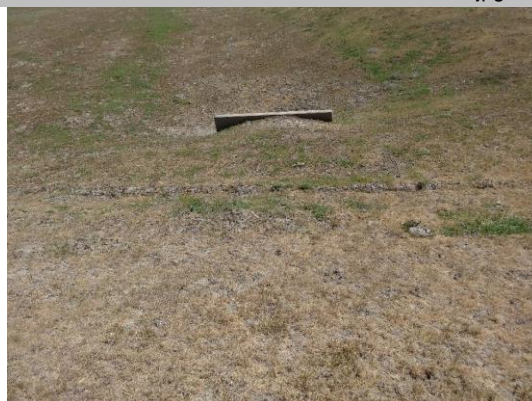
Photo 1 of 3 : UCIP_FA_2019_39472_66462.jpg

LM Start	7.66	Rating **	M	Issue No.	1236
LM End	7.66	Issue Type +	Ma	Location *	
Category	Supplemental			GPS Latitude/Longitude	
				Start	End
Item	DRAFT DWR UCIP LMA Responsibility			37.222743 °	37.222743 °
				-120.716416 °	-120.716416 °
DWR ID	19869				
Comment Code					
Inspector Comment					
DS_ID:19869 FS_ID:39472 EP_NO: N/A Repair Type: Non-Urgent Crossing Status: Found UCIP Comments: 04/18/2014 Some sediment buildup in pipe visible on landward side--recommend clearing. (DWR UCIP - O. Magana) FIELD_STRUCT_DESC: 24-inch corrugated metal gravity drainage pipe through the levee, 11.8 feet below the crown. Flap gate on the waterside (WS) end. Concrete headwall on each end. Skewed crossing. [Additional Reference(s): DWR Levee Log, 2002. USACE San Joaquin O&M Manual 601.1, 1967, (HLM 7.74)]. FS Date: 4/18/2014

View of waterward side.

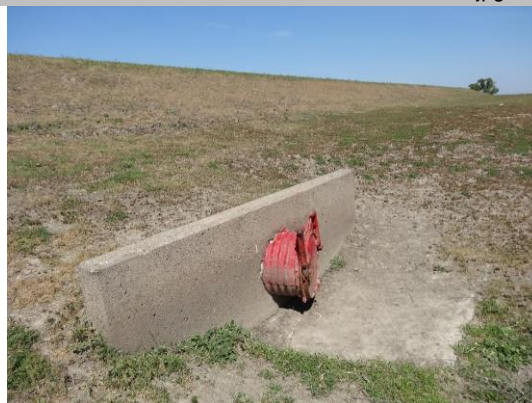
Photo 2 of 3 : UCIP_FA_2019_39472_66461.jpg

Pipe crosses levee at an angle.

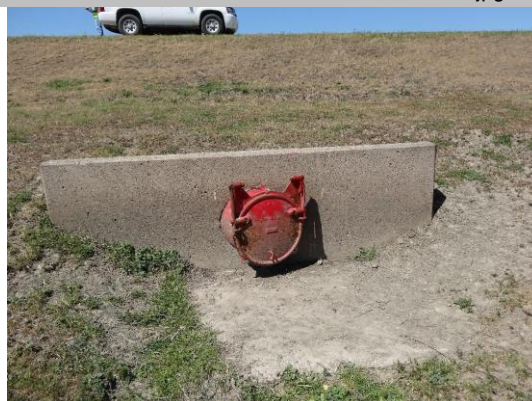
Photo 3 of 3 : UCIP_FA_2019_39472_66460.jpg

Concrete headwall and flap gate visible on waterward side.

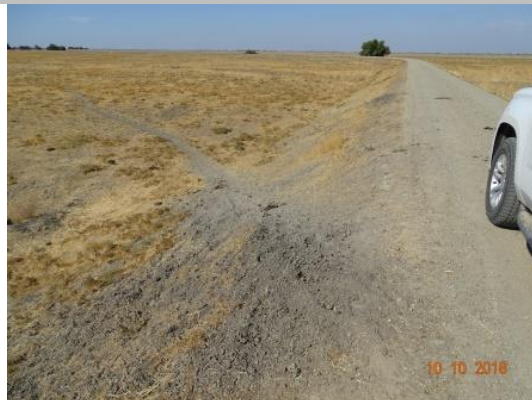
Photo 1 of 1 : FA_2019_NA0010_124_74_20190912_00019.jpg

LM Start	7.66	Rating **	A/W	Issue No.	74
LM End	7.66	Issue Type +	Ma	Location *	LS
Category	Earthen Levee			GPS Latitude/Longitude	
				Start	End
Item	Slope Stability			37.222689 °	37.222689 °
				-120.716400 °	-120.716400 °
DWR ID	DWR_NA0010_06_f_2018_74				
Comment Code					
S2 : Repair the levee slope damaged by foot traffic and prevent access where possible.					
Inspector Comment					
Damage to levee slope from livestock access.

Slope damage from livestock. (Fall 2018)

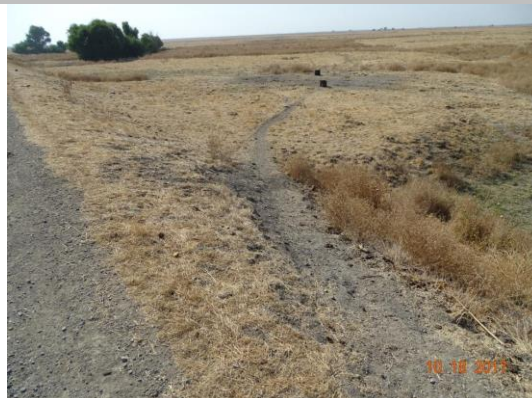
Photo 1 of 1 : FA_2019_NA0010_124_65_20190912_00011.jpg

LM Start	8.08	Rating **	A/W	Issue No.	65
LM End	8.08	Issue Type +	Ma	Location *	LS
Category	Earthen Levee			GPS Latitude/Longitude	
				Start	End
Item	Slope Stability			37.217199°	37.217199°
				-120.713374°	-120.713374°
DWR ID	DWR_NA0010_06_f_2017_65				
Comment Code					
S2 : Repair the levee slope damaged by foot traffic and prevent access where possible.					
Inspector Comment					
Livestock damage to levee slope.

Looking southwest at the landside slope.

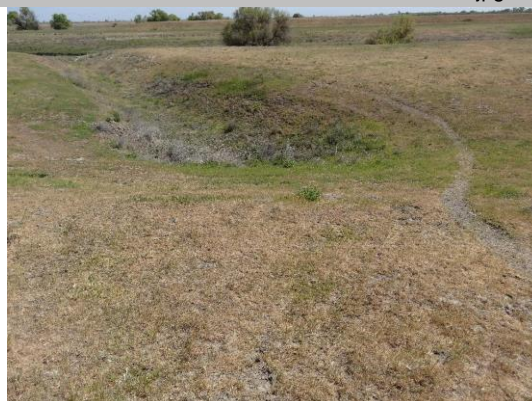
Photo 1 of 3 : UCIP_FA_2019_39473_61674.jpg

LM Start	8.13	Rating **	M	Issue No.	1237
LM End	8.13	Issue Type +	Ma	Location *	
Category	Supplemental			GPS Latitude/Longitude	
				Start	End
Item	DRAFT DWR UCIP LMA Responsibility			37.216547 °	37.216547 °
				-120.713000 °	-120.713000 °
DWR ID	19870				
Comment Code					
Inspector Comment					
DS_ID:19870 FS_ID:39473 EP_NO: N/A Repair Type: Non-Urgent Crossing Status: Found UCIP Comments: 04/18/2014 Sediment buildup in pipe--recommend contacting owner to clear sediment. (DWR UCIP - O. Magana) FIELD_STRUCT_DESC: 24-inch corrugated metal gravity drainage pipe through the levee, 16.5 feet below the crown. Flap gate on the waterside (WS) end. Concrete headwall on each end. [Additional Reference(s): DWR Levee Log, 2002. USACE San Joaquin O&M Manual 601.1, 1967, (HLM 8.21)]. FS Date: 4/18/2014

View of waterward side.

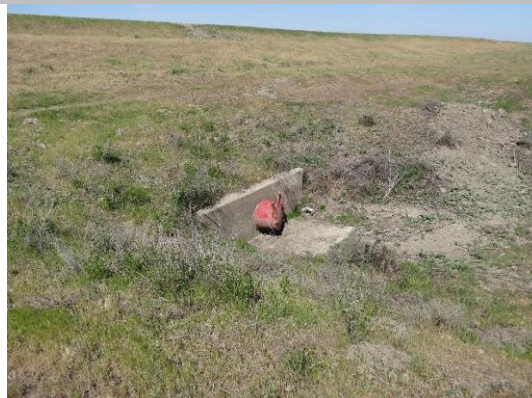
Photo 2 of 3 : UCIP_FA_2019_39473_61673.jpg

LM Start	8.13	Rating **	M	Issue No.	1237 (cont)	
LM End	8.13	Issue Type +	Ma	Location *		
Category	Supplemental			GPS Latitude/Longitude		
				Start		End
Item	DRAFT DWR UCIP LMA Responsibility			37.216547 °		37.216547 °
				-120.713000 °		-120.713000 °
DWR ID	19870					
Comment Code						
Inspector Comment						
DS_ID:19870 FS_ID:39473 EP_NO: N/A Repair Type: Non-Urgent Crossing Status: Found UCIP Comments: 04/18/2014 Sediment buildup in pipe--recommend contacting owner to clear sediment. (DWR UCIP - O. Magana) FIELD_STRUCT_DESC: 24-inch corrugated metal gravity drainage pipe through the levee, 16.5 feet below the crown. Flap gate on the waterside (WS) end. Concrete headwall on each end. [Additional Reference(s): DWR Levee Log, 2002. USACE San Joaquin O&M Manual 601.1, 1967, (HLM 8.21)]. FS Date: 4/18/2014

Pipe crosses levee at an angle.

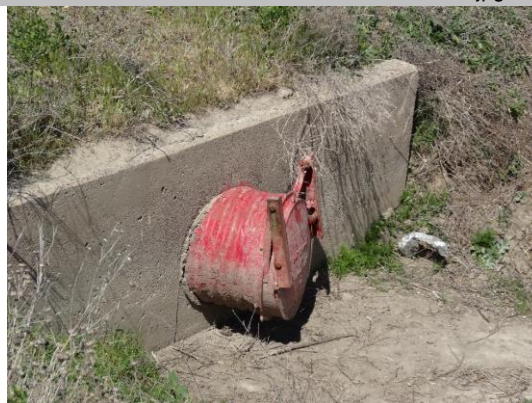
Photo 3 of 3 : UCIP_FA_2019_39473_61672.jpg

Concrete headwall and flap gate visible on waterward side.

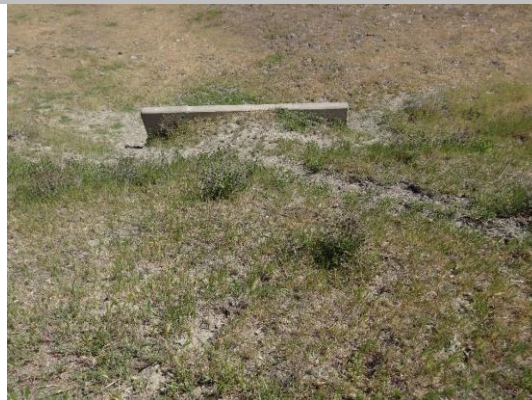
Photo 1 of 3 : UCIP_FA_2019_39474_61685.jpg

Comment Code						
Inspector Comment						
DS_ID:19871 FS_ID:39474 EP_NO: N/A Repair Type: Non-Urgent Crossing Status: Found UCIP Comments: 04/18/2014 Need to contact owner. Sediment buildup in pipe visible on landward side--recommend clearing. Good candidate for pressure test or video inspection due to signs of heavy corrosion. If no leaks after tests this crossing would be a good candidate for rehabilitation. (DWR UCIP - O. Magana) FIELD_STRUCT_DESC: 24-inch corrugated metal gravity drainage pipe through the levee, 9.2 feet below the crown. Flap gate on the waterside (WS) end. Concrete headwall on each end. [Additional Reference(s): DWR Levee Log, 2002. USACE San Joaquin O&M Manual 601.1, 1967, (HLM 8.51)]. FS Date: 4/18/2014

View of waterward side.

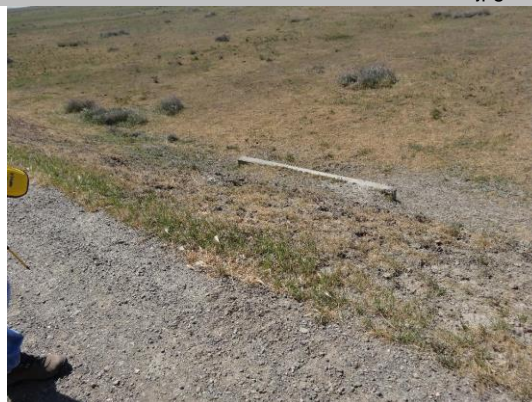
Photo 2 of 3 : UCIP_FA_2019_39474_61684.jpg

View of landward side.

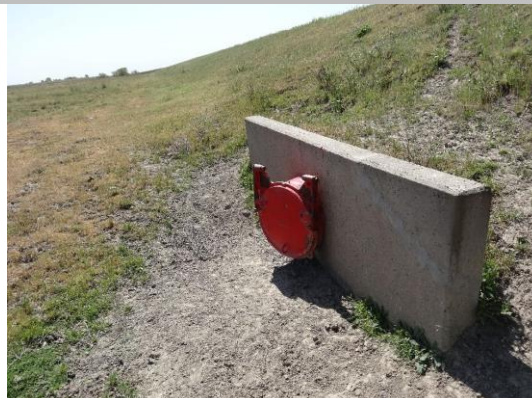
Photo 3 of 3 : UCIP_FA_2019_39474_61683.jpg

Comment Code					
Inspector Comment					
DS_ID:19871 FS_ID:39474 EP_NO: N/A Repair Type: Non-Urgent Crossing Status: Found UCIP Comments: 04/18/2014 Need to contact owner. Sediment buildup in pipe visible on landward side--recommend clearing. Good candidate for pressure test or video inspection due to signs of heavy corrosion. If no leaks after tests this crossing would be a good candidate for rehabilitation. (DWR UCIP - O. Magana) FIELD_STRUCT_DESC: 24-inch corrugated metal gravity drainage pipe through the levee, 9.2 feet below the crown. Flap gate on the waterside (WS) end. Concrete headwall on each end. [Additional Reference(s): DWR Levee Log, 2002. USACE San Joaquin O&M Manual 601.1, 1967, (HLM 8.51)]. FS Date: 4/18/2014

Pipe crosses levee at an angle.

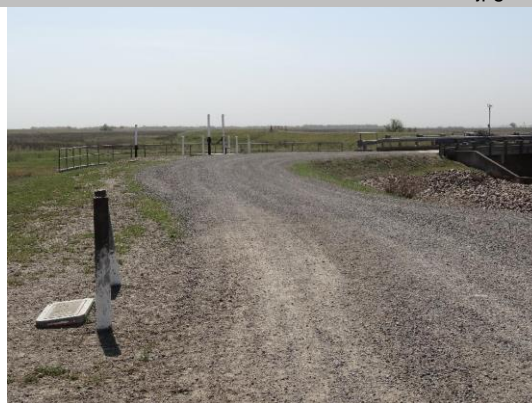
Photo 1 of 2 : UCIP_FA_2019_42525_72925.jpg

LM Start	9.52	Rating **	M	Issue No.	1239
LM End	9.52	Issue Type +	En	Location *	
Category	Supplemental			GPS Latitude/Longitude	
				Start	End
Item	DRAFT DWR UCIP Field Study			37.202481°	37.202481°
				-120.695303°	-120.695303°
DWR ID	19872				
Comment Code					
Inspector Comment					
DS_ID:19872 FS_ID:42525 EP_NO: N/A Repair Type: Non-Urgent Crossing Status: Indicator Found UCIP Comments: 12/05/2014 Accidently missed updating record. Photos have been added and coordinates have been updated. Unable to confirm if crossing is the same cable line originally identified in desk study at levee mile 6.43. Recommend contacting owner to confirm alignment, size of conduit, and permit issued. (DWR UCIP - O. Magana) FIELD_STRUCT_DESC: Telephone cable of an unknown size or material under crown of roadway, at an unknown depth. [Additional Reference(s): DWR Levee Log, 2002]. FS Date: 4/18/2014

Service box located on waterward levee shoulder.

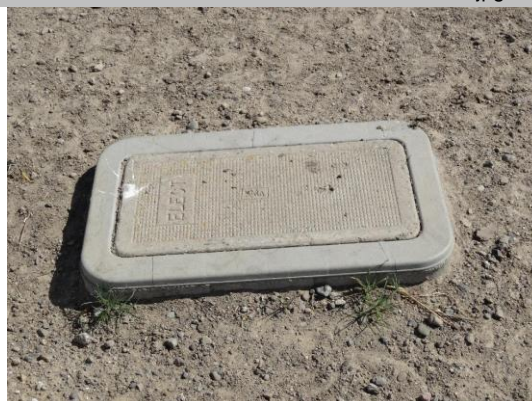
Photo 2 of 2 : UCIP_FA_2019_42525_72924.jpg

Comment Code					
Inspector Comment					
DS_ID:19872 FS_ID:42525 EP_NO: N/A Repair Type: Non-Urgent Crossing Status: Indicator Found UCIP Comments: 12/05/2014 Accidentally missed updating record. Photos have been added and coordinates have been updated. Unable to confirm if crossing is the same cable line originally identified in desk study at levee mile 6.43. Recommend contacting owner to confirm alignment, size of conduit, and permit issued. (DWR UCIP - O. Magana) FIELD_STRUCT_DESC: Telephone cable of an unknown size or material under crown of roadway, at an unknown depth. [Additional Reference(s): DWR Levee Log, 2002]. FS Date: 4/18/2014

Service box is for electrical conduit.

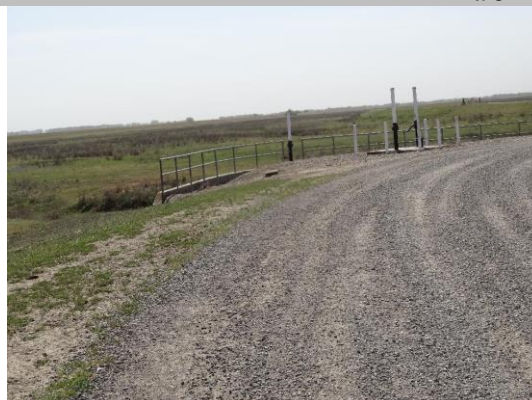
Photo 1 of 3 : UCIP_FA_2019_42524_72922.jpg

Comment Code					
Inspector Comment					
DS_ID:19873 FS_ID:42524 EP_NO: N/A Repair Type: Non-Urgent Crossing Status: Found UCIP Comments: 12/05/2014 Accidentally missed entry. Photos have been added and coordinates have been updated by Olivia Magana. Unable to determine condition of crossing due to limited access. Recommend contacting owner to provide condition of crossing. (DWR UCIP - O. Magana) FIELD_STRUCT_DESC: 36-inch corrugated metal gravity drainage pipe through the levee, 14 feet below the crown. Slide gate in a concrete diversion box on the waterside (WS) shoulder. [Additional Reference(s): DWR Levee Log, 2002]. FS Date: 4/18/2014

Overview of levee crown looking upstream.

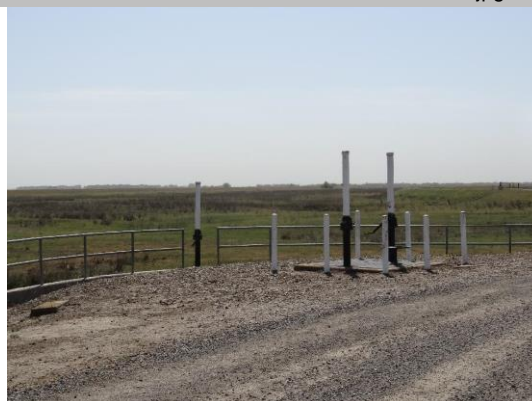
Photo 2 of 3 : UCIP_FA_2019_42524_72921.jpg

Comment Code						
Inspector Comment						
DS_ID:19873 FS_ID:42524 EP_NO: N/A Repair Type: Non-Urgent Crossing Status: Found UCIP Comments: 12/05/2014 Accidentally missed entry. Photos have been added and coordinates have been updated by Olivia Magana. Unable to determine condition of crossing due to limited access. Recommend contacting owner to provide condition of crossing. (DWR UCIP - O. Magana) FIELD_STRUCT_DESC: 36-inch corrugated metal gravity drainage pipe through the levee, 14 feet below the crown. Slide gate in a concrete diversion box on the waterside (WS) shoulder. [Additional Reference(s): DWR Levee Log, 2002]. FS Date: 4/18/2014

Concrete box located on waterward side.

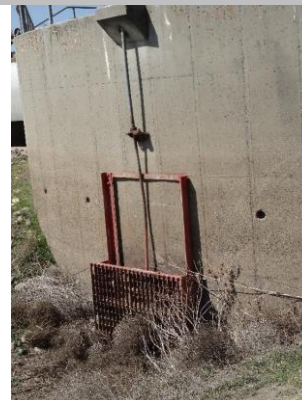
Photo 3 of 3 : UCIP_FA_2019_42524_72920.jpg

Trash gate visible on waterward side.

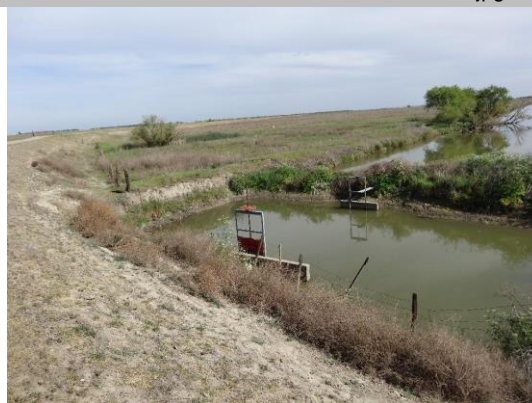
Photo 1 of 2 : UCIP_FA_2019_39475_61691.jpg

LM Start	9.66	Rating **	M	Issue No.	1246
LM End	9.66	Issue Type +	En	Location *	
Category	Supplemental			GPS Latitude/Longitude	
				Start	End
Item	DRAFT DWR UCIP Field Study			37.200948 °	37.200948 °
				-120.694362 °	-120.694362 °
DWR ID	19874				
Comment Code					
Inspector Comment					
DS_ID:19874 FS_ID:39475 EP_NO: N/A Repair Type: Non-Urgent Crossing Status: Found UCIP Comments: 04/17/2014 Waterward side not visible--need to determine alignment. (DWR UCIP - O. Magana) FIELD_STRUCT_DESC: 36-inch corrugated metal gravity drainage pipe through the levee, 14 feet below the crown. Slide gate in a concrete diversion box on the waterside (WS) shoulder. [Additional Reference(s): DWR Levee Log, 2002]. FS Date: 4/17/2014

View of landward side.

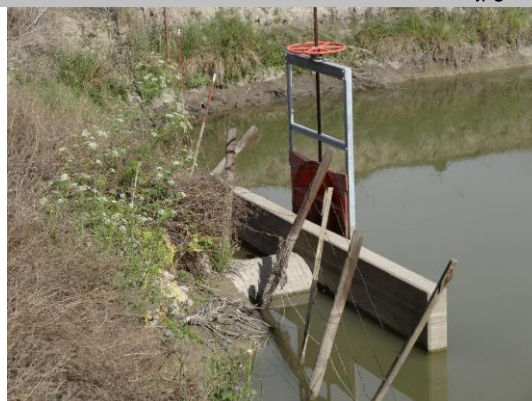
Photo 2 of 2 : UCIP_FA_2019_39475_61690.jpg

LM Start	9.66	Rating **	M	Issue No.	1246 (cont)	
LM End	9.66	Issue Type +	En	Location *		
Category	Supplemental			GPS Latitude/Longitude		
				Start	End	
Item	DRAFT DWR UCIP Field Study			37.200948 °	37.200948 °	
				-120.694362 °	-120.694362 °	
DWR ID	19874					
Comment Code						
Inspector Comment						
DS_ID:19874 FS_ID:39475 EP_NO: N/A Repair Type: Non-Urgent Crossing Status: Found UCIP Comments: 04/17/2014 Waterward side not visible--need to determine alignment. (DWR UCIP - O. Magana) FIELD_STRUCT_DESC: 36-inch corrugated metal gravity drainage pipe through the levee, 14 feet below the crown. Slide gate in a concrete diversion box on the waterside (WS) shoulder. [Additional Reference(s): DWR Levee Log, 2002]. FS Date: 4/17/2014

Pipe, slide gate, and concrete headwall visible on landward side.

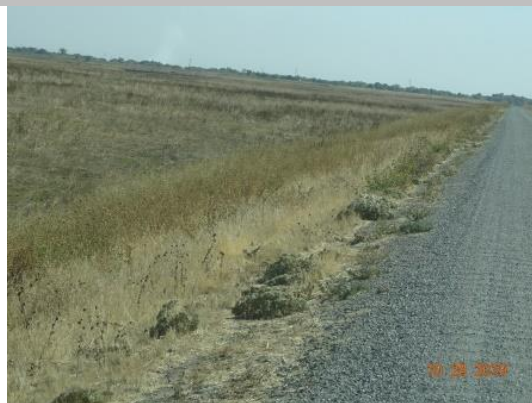
Photo 1 of 1 : FA_2019_NA0010_124_96_20191112_00199.jpg

LM Start	10.05	Rating **	U	Issue No.	96
LM End	15.70	Issue Type +	Ma	Location *	WS
Category	Earthen Levee			GPS Latitude/Longitude	
				Start	End
Item	Vegetation			37.197661 °	37.156746 °
				-120.688808 °	-120.616955 °
DWR ID	DWR_NA0010_06_f_2019_96				
Comment Code					
V1 : Control annual grass and weeds on the levee slopes and easements.					
Inspector Comment

View of the waterside slope looking upstream. (Fall 2019)

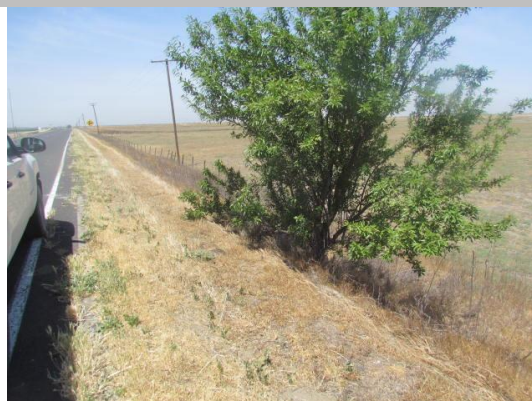
Photo 1 of 1 : FA_2019_NA0010_124_14_20190912_00010.jpg

LM Start	11.49	Rating **	M	Issue No.	14
LM End	11.49	Issue Type +	Ma	Location *	WS
Category	Earthen Levee			GPS Latitude/Longitude	
				Start	End
Item	Trim / Thin Trees			37.186189 °	37.186189 °
				-120.668476 °	-120.668476 °
DWR ID	DWR_NA0010_06_s_2015_14				
Comment Code					
T1 : Trim trees to at least five feet above ground level.					
Inspector Comment					
Almond tree located along Sandy Mush Road on waterside slope.

Looking west at tree on waterward slope.

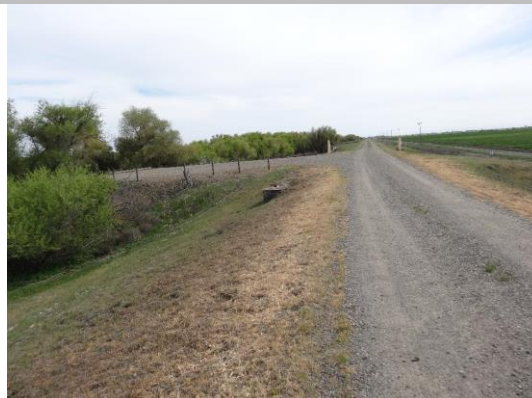
Photo 1 of 3 : UCIP_FA_2019_39476_66488.jpg

LM Start	11.74	Rating **	M	Issue No.	1248
LM End	11.74	Issue Type +	Ma	Location *	
Category	Supplemental			GPS Latitude/Longitude	
				Start	End
Item	DRAFT DWR UCIP LMA Responsibility			37.185513 °	37.185513 °
				-120.664561 °	-120.664561 °
DWR ID	19876				
Comment Code					
Inspector Comment					
DS_ID:19876 FS_ID:39476 EP_NO: N/A Repair Type: Non-Urgent Crossing Status: Found UCIP Comments: 04/17/2014 Clear debris from waterward and landward toes. (DWR UCIP - O. Magana) FIELD_STRUCT_DESC: 36-inch corrugated metal gravity drainage pipe through the levee, 17 feet below the crown. Slide gate in a pipe riser on the waterside (WS) slope. [Additional Reference(s): DWR Levee Log, 2002. USACE San Joaquin O&M Manual 601.1, 1967, (HLM 11.82)]. FS Date: 4/17/2014

View of waterward side.

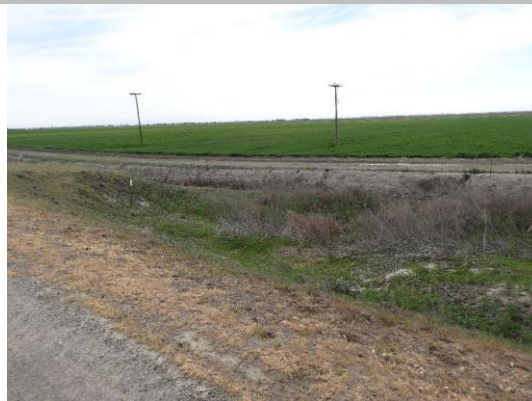
Photo 2 of 3 : UCIP_FA_2019_39476_66487.jpg

View of landward side.

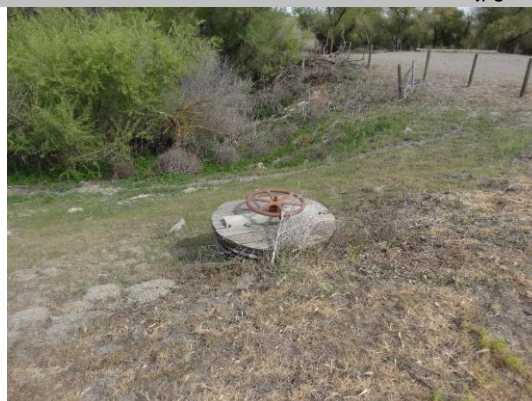
Photo 3 of 3 : UCIP_FA_2019_39476_66486.jpg

LM Start	11.74	Rating **	M	Issue No.	1248 (cont)	
LM End	11.74	Issue Type +	Ma	Location *		
Category	Supplemental			GPS Latitude/Longitude		
				Start	End	
Item	DRAFT DWR UCIP LMA Responsibility			37.185513 °	37.185513 °	
				-120.664561 °	-120.664561 °	
DWR ID	19876					
Comment Code						
Inspector Comment						
DS_ID:19876 FS_ID:39476 EP_NO: N/A Repair Type: Non-Urgent Crossing Status: Found UCIP Comments: 04/17/2014 Clear debris from waterward and landward toes. (DWR UCIP - O. Magana) FIELD_STRUCT_DESC: 36-inch corrugated metal gravity drainage pipe through the levee, 17 feet below the crown. Slide gate in a pipe riser on the waterside (WS) slope. [Additional Reference(s): DWR Levee Log, 2002. USACE San Joaquin O&M Manual 601.1, 1967, (HLM 11.82)]. FS Date: 4/17/2014

Slide gate inside CMP riser located on waterward slope.

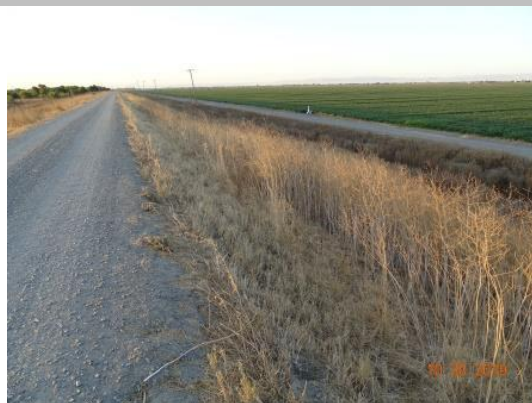
Photo 1 of 1 : FA_2019_NA0010_124_97_20191112_00200.jpg

LM Start	11.77	Rating **	U	Issue No.	97
LM End	13.70	Issue Type +	Ma	Location *	LS
Category	Earthen Levee			GPS Latitude/Longitude	
				Start	End
Item	Vegetation			37.185015 °	37.171633 °
				-120.664575 °	-120.646295 °
DWR ID	DWR_NA0010_06_f_2019_97				
Comment Code					
V1 : Control annual grass and weeds on the levee slopes and easements.					
Inspector Comment

View of the landside slope looking upstream. (Fall 2019)

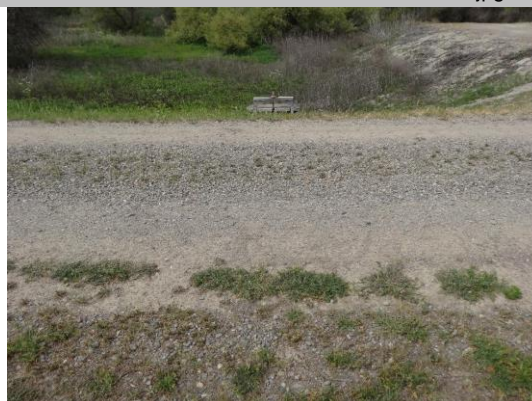
Photo 1 of 3 : UCIP_FA_2019_39477_66492.jpg

LM Start	13.22	Rating **	M	Issue No.	1249
LM End	13.22	Issue Type +	Ma	Location *	
Category	Supplemental			GPS Latitude/Longitude	
				Start	End
Item	DRAFT DWR UCIP LMA Responsibility			37.171675 °	37.171675 °
				-120.655064 °	-120.655064 °
DWR ID	19877				
Comment Code					
Inspector Comment					
DS_ID:19877 FS_ID:39477 EP_NO: N/A Repair Type: Non-Urgent Crossing Status: Found UCIP Comments: 04/17/2014 Not accessible--crossing is buried on landward side. Need to contact owner to determine status. (DWR UCIP - O. Magana) FIELD_STRUCT_DESC: 24-inch corrugated metal gravity drainage pipe through the levee, 10.8 feet below the crown. Flap gate on the waterside (WS) end. [Additional Reference(s): DWR Levee Log, 2002. USACE San Joaquin O&M Manual 601.1, 1967, (HLM 13.30)]. FS Date: 4/17/2014

View of levee crown at crossing.

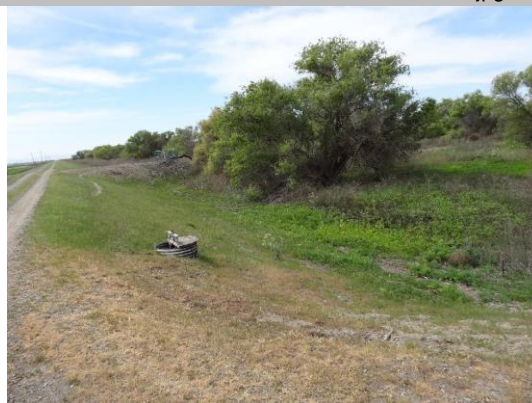
Photo 2 of 3 : UCIP_FA_2019_39477_66494.jpg

View of waterward slope.

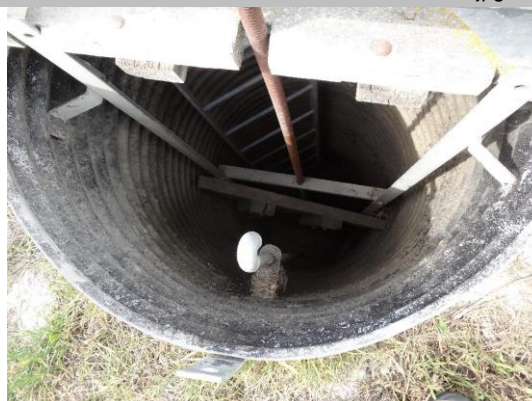
Photo 3 of 3 : UCIP_FA_2019_39477_66495.jpg

LM Start	13.22	Rating **	M	Issue No.	1249 (cont)	
LM End	13.22	Issue Type +	Ma	Location *		
Category	Supplemental			GPS Latitude/Longitude		
				Start	End	
Item	DRAFT DWR UCIP LMA Responsibility			37.171675 °	37.171675 °	
				-120.655064 °	-120.655064 °	
DWR ID	19877					
Comment Code						
Inspector Comment						
DS_ID:19877 FS_ID:39477 EP_NO: N/A Repair Type: Non-Urgent Crossing Status: Found UCIP Comments: 04/17/2014 Not accessible--crossing is buried on landward side. Need to contact owner to determine status. (DWR UCIP - O. Magana) FIELD_STRUCT_DESC: 24-inch corrugated metal gravity drainage pipe through the levee, 10.8 feet below the crown. Flap gate on the waterside (WS) end. [Additional Reference(s): DWR Levee Log, 2002. USACE San Joaquin O&M Manual 601.1, 1967, (HLM 13.30)]. FS Date: 4/17/2014

Inside view of CMP riser located on waterward slope.

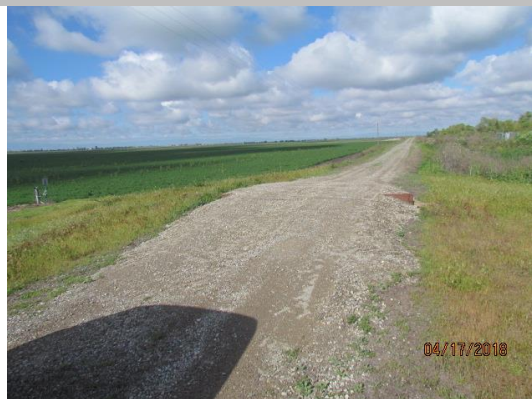
Photo 1 of 2 : FA_2019_NA0010_124_88_20190912_00031.jpg

LM Start	13.23	Rating **	M	Issue No.	88
LM End	13.23	Issue Type +	En	Location *	CR
Category	Earthen Levee			GPS Latitude/Longitude	
				Start	End
Item	Encroachments			37.171678 °	37.171678 °
				-120.654920 °	-120.654920 °
DWR ID	DWR_NA0010_06_s_2018_88				
Comment Code					
PI : Pipe					
Inspector Comment					
Landowner or farmer installed a temporary 4-inch pipe across levee crown.

Looking north at pipe across levee crown. (Spring 2018)

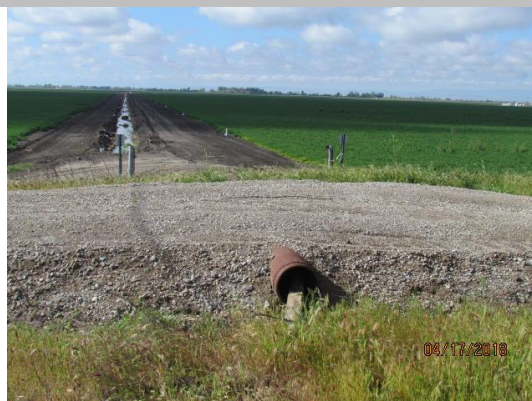
Photo 2 of 2 : FA_2019_NA0010_124_88_20190912_00032.jpg

LM Start	13.23	Rating **	M	Issue No.	88 (cont)	
LM End	13.23	Issue Type +	En	Location *	CR	
Category	Earthen Levee			GPS Latitude/Longitude		
				Start		End
Item	Encroachments			37.171678 °	37.171678 °	
				-120.654920 °	-120.654920 °	
DWR ID	DWR_NA0010_06_s_2018_88					
Comment Code						
PI : Pipe						
Inspector Comment						
Landowner or farmer installed a temporary 4-inch pipe across levee crown.

Looking east at pipe across levee crown. (Spring 2018)

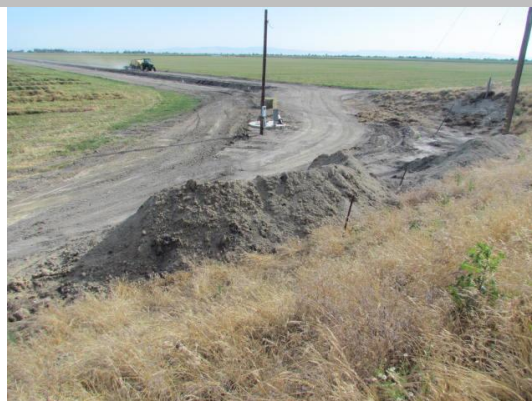
Photo 1 of 1 : FA_2019_NA0010_124_68_20190912_00014.jpg

LM Start	13.24	Rating **	M	Issue No.	68
LM End	13.24	Issue Type +	En	Location *	LS
Category	Earthen Levee			GPS Latitude/Longitude	
				Start	End
Item	Encroachments			37.171686 °	37.171686 °
				-120.654562 °	-120.654562 °
DWR ID	DWR_NA0010_06_f_2015_68				
Comment Code					
MA : Material					
Inspector Comment					
Landowner stockpiled dirt at landside toe.

Looking west at dirt stockpile at landward toe.

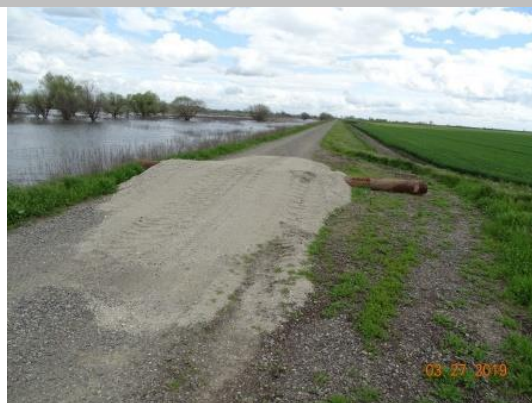
Photo 1 of 2 : FA_2019_NA0010_124_116_20190912_00044.jpg

LM Start	13.48	Rating **	U	Issue No.	116
LM End	13.48	Issue Type +	En	Location *	CR
Category	Earthen Levee			GPS Latitude/Longitude	
				Start	End
Item	Encroachments			37.171651 °	37.171651 °
				-120.650354 °	-120.650354 °
DWR ID	DWR_NA0010_06_s_2019_116				
Comment Code					
PI : Pipe					
Inspector Comment					
Landowner or farmer installed a pipe across levee crown.

View of pipe encroachment looking upstream. (Spring 2019)

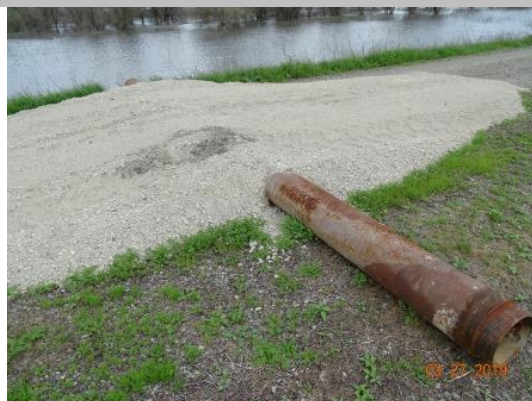
Photo 2 of 2 : FA_2019_NA0010_124_116_20190912_00045.jpg

LM Start	13.48	Rating **	U	Issue No.	116 (cont)	
LM End	13.48	Issue Type +	En	Location *	CR	
Category	Earthen Levee			GPS Latitude/Longitude		
				Start		End
Item	Encroachments			37.171651 °		37.171651 °
				-120.650354 °		-120.650354 °
DWR ID	DWR_NA0010_06_s_2019_116					
Comment Code						
PI : Pipe						
Inspector Comment						
Landowner or farmer installed a pipe across levee crown.

View of pipe encroachment looking East. (Spring 2019)

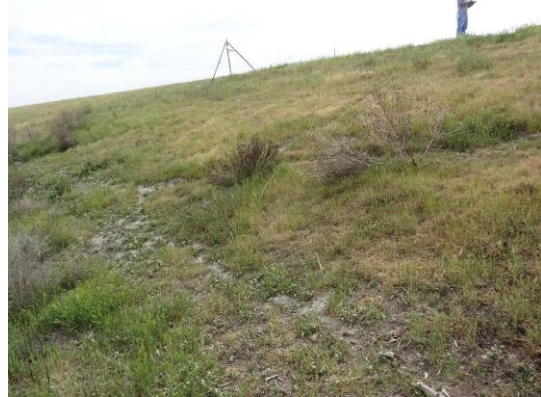
Photo 1 of 3 : UCIP_FA_2019_39478_66496.jpg

LM Start	14.36	Rating **	M	Issue No.	1250	
LM End	14.36	Issue Type +	Ma	Location *		
Category	Supplemental			GPS Latitude/Longitude		
				Start	End	
Item	DRAFT DWR UCIP LMA Responsibility			37.167888 °	37.167888 °	
				-120.636419 °	-120.636419 °	
DWR ID	19878					
Comment Code						
Inspector Comment						
DS_ID:19878 FS_ID:39478 EP_NO: N/A Repair Type: Non-Urgent Crossing Status: Found UCIP Comments: 04/17/2014 Not accessible--crossing is buried on landward side. Need to contact owner to determine status. (DWR UCIP - O. Magana) FIELD_STRUCT_DESC: 24-inch corrugated metal gravity drainage pipe through the levee, 12.3 feet below the crown. Flap gate on the waterside (WS) end. [Additional Reference(s): DWR Levee Log, 2002. USACE San Joaquin O&M Manual 601.1, 1967, (HLM 14.44)]. FS Date: 4/17/2014

View of waterward slope.

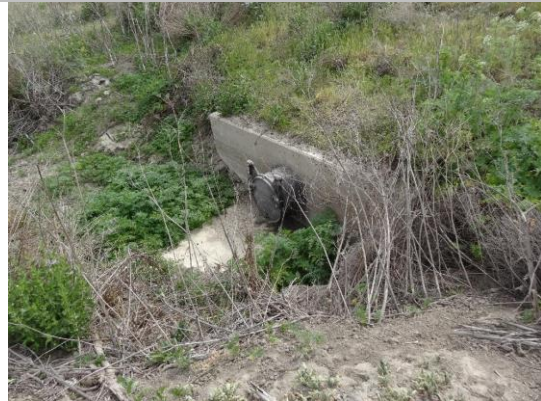
Photo 2 of 3 : UCIP_FA_2019_39478_66497.jpg

View of pipe daylight, flap gate, and concrete headwall visible on waterward toe.

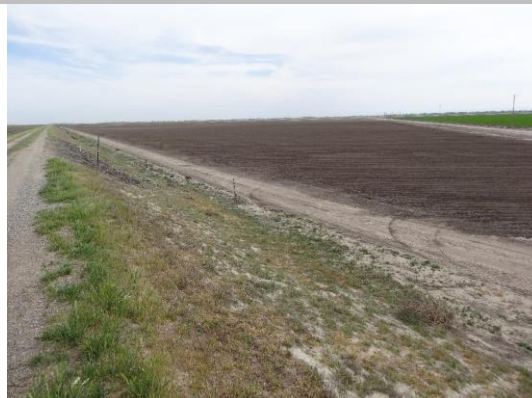
Photo 3 of 3 : UCIP_FA_2019_39478_66498.jpg

LM Start	14.36	Rating **	M	Issue No.	1250 (cont)
LM End	14.36	Issue Type +	Ma	Location *	
Category	Supplemental			GPS Latitude/Longitude	
				Start	End
Item	DRAFT DWR UCIP LMA Responsibility			37.167888 °	37.167888 °
				-120.636419 °	-120.636419 °
DWR ID	19878				
Comment Code					
Inspector Comment					
DS_ID:19878 FS_ID:39478 EP_NO: N/A Repair Type: Non-Urgent Crossing Status: Found UCIP Comments: 04/17/2014 Not accessible--crossing is buried on landward side. Need to contact owner to determine status. (DWR UCIP - O. Magana) FIELD_STRUCT_DESC: 24-inch corrugated metal gravity drainage pipe through the levee, 12.3 feet below the crown. Flap gate on the waterside (WS) end. [Additional Reference(s): DWR Levee Log, 2002. USACE San Joaquin O&M Manual 601.1, 1967, (HLM 14.44)]. FS Date: 4/17/2014

View of landward slope.
