**Flood Control Project Maintenance
Levee Inspections**

Fall 2019 Levee Maintenance Deficiency Summary Report

San Joaquin River Basin

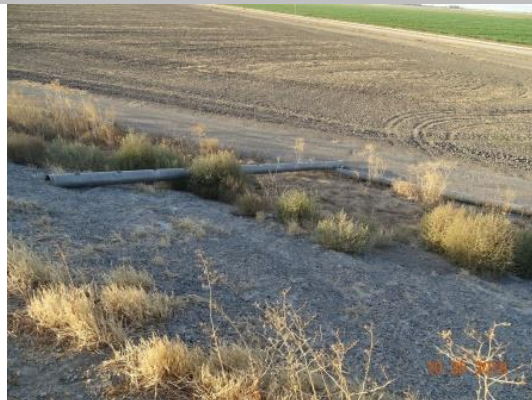
Photo 1 of 1 : FA_2019_NA0010_124_99_20191112_00201.jpg

LM Start	14.36	Rating **	M	Issue No.	99
LM End	14.36	Issue Type +	En	Location *	LS
Category	Earthen Levee			GPS Latitude/Longitude	
				Start	End
Item	Encroachments			37.167825 °	37.167825 °
				-120.636347 °	-120.636347 °
DWR ID	DWR_NA0010_06_f_2019_99				
Comment Code					
PI : Pipe					
Inspector Comment					
Pipe left on landside slope and toe.

View of pipe on landside slope and toe. (Fall 2019)

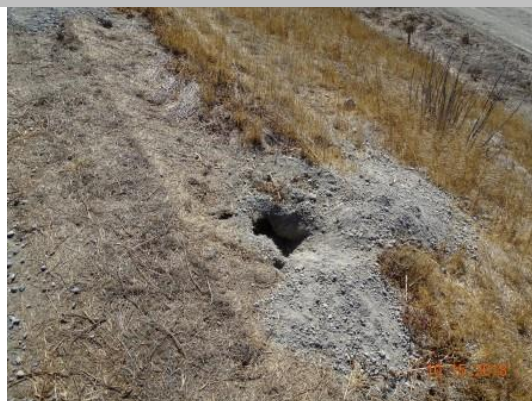
Photo 1 of 1 : FA_2019_NA0010_124_101_20190912_00037.jpg

LM Start	14.63	Rating **	M	Issue No.	101
LM End	14.64	Issue Type +	Ma	Location *	LS
Category	Earthen Levee			GPS Latitude/Longitude	
				Start	End
Item	Animal Control			37.164871 °	37.164824 °
				-120.633222 °	-120.633167 °
DWR ID	DWR_NA0010_06_f_2018_101				
Comment Code					
A3 : No rodents visible, but rodent burrows visible; need to backfill and compact or grout burrows.					
Inspector Comment					
Burrows are located along landside shoulder.

View of rodent hole on landside shoulder. (Fall 2018)

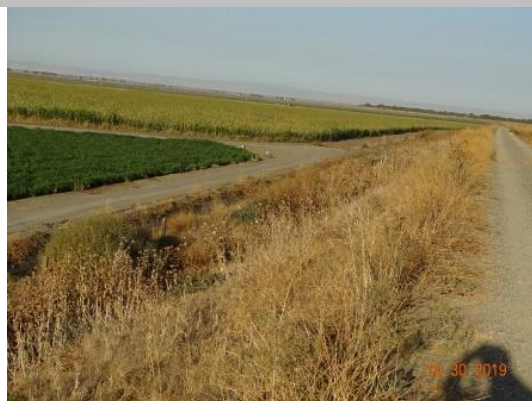
Photo 1 of 1 : FA_2019_NA0010_124_100_20191112_00202.jpg

LM Start	15.08	Rating **	U	Issue No.	100
LM End	15.70	Issue Type +	Ma	Location *	LS
Category	Earthen Levee			GPS Latitude/Longitude	
				Start	End
Item	Vegetation			37.161387 °	37.156746 °
				-120.626546 °	-120.616954 °
DWR ID	DWR_NA0010_06_f_2019_100				
Comment Code					
V1 : Control annual grass and weeds on the levee slopes and easements.					
Inspector Comment

View of landside slope looking downstream. (Fall 2019)

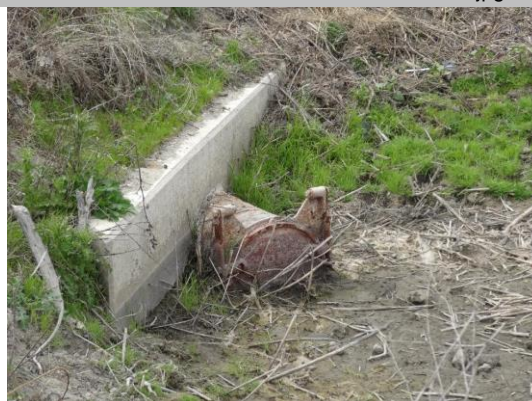
Photo 1 of 3 : UCIP_FA_2019_39480_66507.jpg

Comment Code						
Inspector Comment						
DS_ID:19884 FS_ID:39480 EP_NO: N/A Repair Type: Non-Urgent Crossing Status: Found UCIP Comments: 04/17/2014 Need to contact owner. Sediment buildup on both the waterward and landward side. Recommend removing sediment buildup from both side. Also recommend clearing excess sediment inside crossing. (DWR UCIP - O. Magana) FIELD_STRUCT_DESC: 24-inch corrugated metal gravity drainage pipe through the levee, 14 feet below the crown. Flap gate on the waterside (WS) end. [Additional Reference(s): DWR Levee Log, 2002. USACE San Joaquin O&M Manual 601.1, 1967, (HLM 15.76)]. FS Date: 4/17/2014

Flap gate buried halfway on waterward side.

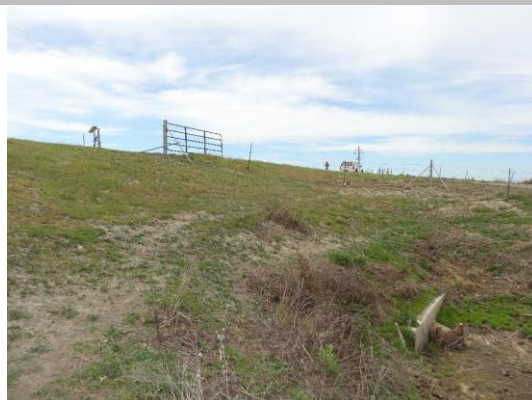
Photo 2 of 3 : UCIP_FA_2019_39480_66506.jpg

View of waterward side.

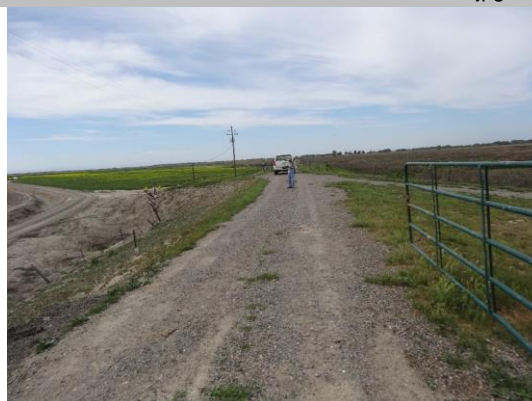
Photo 3 of 3 : UCIP_FA_2019_39480_66505.jpg

Item	DRAFT DWR UCIP LMA Responsibility			37.156934 °		37.156934 °
				-120.617210 °		-120.617210 °
DWR ID	19884					
Comment Code						
Inspector Comment						
DS_ID:19884						
FS_ID:39480						
EP_NO: N/A						
Repair Type: Non-Urgent						
Crossing Status: Found						
UCIP Comments: 04/17/2014 Need to contact owner. Sediment buildup on both the waterward and landward side. Recommend removing sediment buildup from both side. Also recommend clearing excess sediment inside crossing. (DWR UCIP - O. Magana)						
FIELD_STRUCT_DESC: 24-inch corrugated metal gravity drainage pipe through the levee, 14 feet below the crown. Flap gate on the waterside (WS) end. [Additional Reference(s): DWR Levee Log, 2002. USACE San Joaquin O&M Manual 601.1, 1967, (HLM 15.76)].						
FS Date: 4/17/2014

Overview of levee crown at crossing.

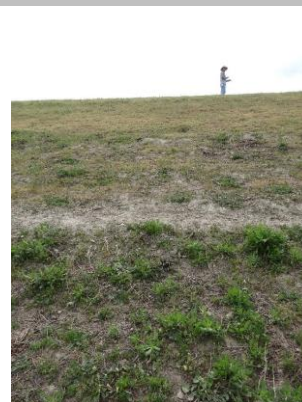
Photo 1 of 3 : UCIP_FA_2019_36663_66530.jpg

Comment Code					
Inspector Comment					
DS_ID:19885 FS_ID:36663 EP_NO: N/A Repair Type: Non-Urgent Crossing Status: Found UCIP Comments: 04/17/2014 Need to contact owner to determine status of crossing. Waterward side is buried and not accessible. Landward side headwall is blocked by dense vegetation. Recommend confirming status of flap gate on waterward side and removing dense vegetation form landward side. (DWR UCIP - O. Magana) FIELD_STRUCT_DESC: 36-inch corrugated metal gravity drainage pipe through the levee, 16.6 feet below the crown. Flap gate on the waterside (WS) end. [Additional Reference(s): DWR Levee Log, 2002. USACE San Joaquin O&M Manual 601.1, 1967, (HLM 15.91)]. FS Date: 4/17/2014

View of waterward side, Photo 1 of 3.

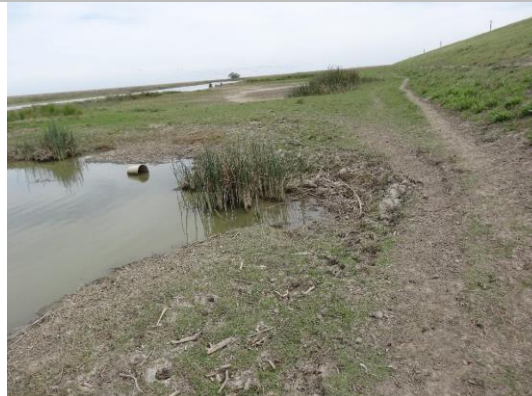
Photo 2 of 3 : UCIP_FA_2019_36663_66526.jpg

Item	DRAFT DWR UCIP LMA Responsibility			37.155539 °		37.155539 °
				-120.615303 °		-120.615303 °
DWR ID	19885					
Comment Code						
Inspector Comment						
DS_ID:19885						
FS_ID:36663						
EP_NO: N/A						
Repair Type: Non-Urgent						
Crossing Status: Found						
UCIP Comments: 04/17/2014 Need to contact owner to determine status of crossing. Waterward side is buried and not accessible. Landward side headwall is blocked by dense vegetation. Recommend confirming status of flap gate on waterward side and removing dense vegetation form landward side. (DWR UCIP - O. Magana)						
FIELD_STRUCT_DESC: 36-inch corrugated metal gravity drainage pipe through the levee, 16.6 feet below the crown. Flap gate on the waterside (WS) end. [Additional Reference(s): DWR Levee Log, 2002. USACE San Joaquin O&M Manual 601.1, 1967, (HLM 15.91)].						
FS Date: 4/17/2014

View of waterward side, photo 2 of 3.

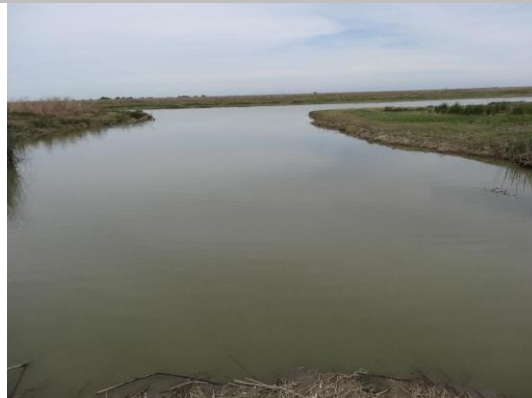
Photo 3 of 3 : UCIP_FA_2019_36663_66529.jpg

View of waterward side, photo 3 of 3.

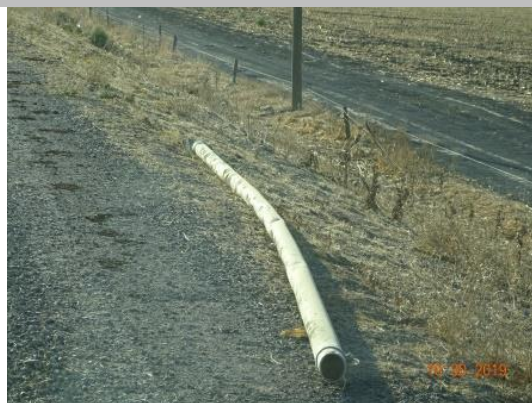
Photo 1 of 1 : FA_2019_NA0010_124_103_20191112_00204.jpg

LM Start	16.15	Rating **	M	Issue No.	103
LM End	16.15	Issue Type +	En	Location *	LS
Category	Earthen Levee			GPS Latitude/Longitude	
				Start	End
Item	Encroachments			37.152394 °	37.152394 °
				-120.610964 °	-120.610964 °
DWR ID	DWR_NA0010_06_f_2019_103				
Comment Code					
PI : Pipe					
Inspector Comment					
Pipe left on landside shoulder.

Pipe section left on the landside shoulder. (Fall 2019)

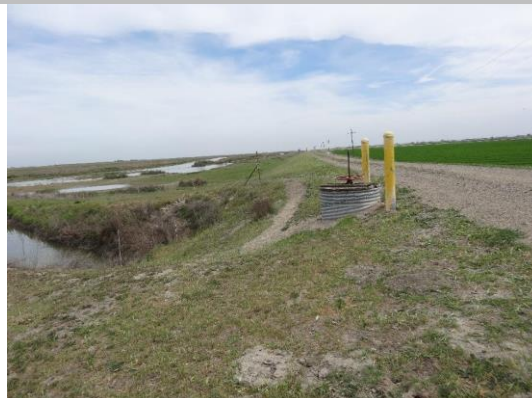
Photo 1 of 3 : UCIP_FA_2019_36665_66541.jpg

LM Start	16.40	Rating **	M	Issue No.	1253
LM End	16.40	Issue Type +	En	Location *	
Category	Supplemental			GPS Latitude/Longitude	
				Start	End
Item	DRAFT DWR UCIP Field Study			37.149747 °	37.149747 °
				-120.607702 °	-120.607702 °
DWR ID	19559				
Comment Code					
Inspector Comment					
DS_ID:19559 FS_ID:36665 EP_NO: N/A Repair Type: Non-Urgent Crossing Status: Found UCIP Comments: 04/17/2014 Need to contact owner to determine status of crossing. Unable to confirm pipe diameter. (DWR UCIP - O. Magana) FIELD_STRUCT_DESC: 36-inch corrugated metal irrigation siphon pipe through the levee, 5.9 feet below the crown. Slide gate on the waterside (WS). Siphon extends under channel. [Additional Reference(s): USACE San Joaquin O&M Manual 601.1, 1967, (HLM 16.49)]. FS Date: 4/17/2014

View of waterward side.

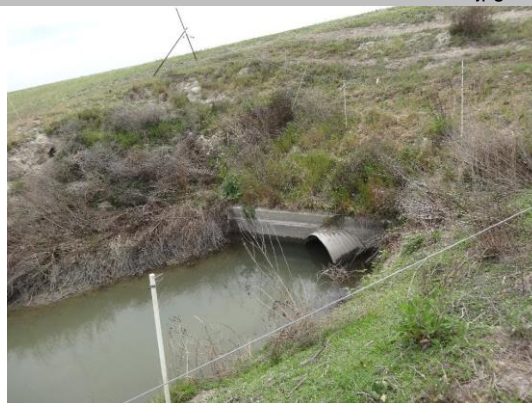
Photo 2 of 3 : UCIP_FA_2019_36665_66539.jpg

Concrete headwall and pipe visible on waterward side.

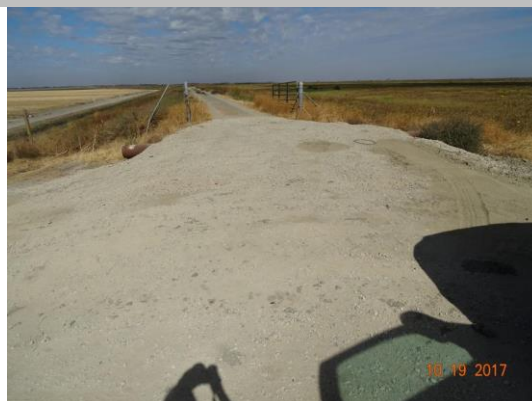
Photo 1 of 1 : FA_2019_NA0010_124_72_20190912_00018.jpg

LM Start	18.18	Rating **	U	Issue No.	72
LM End	18.18	Issue Type +	En	Location *	CR
Category	Earthen Levee			GPS Latitude/Longitude	
				Start	End
Item	Encroachments			37.127982 °	37.127982 °
				-120.590911 °	-120.590911 °
DWR ID	DWR_NA0010_06_f_2017_72				
Comment Code					
PI : Pipe					
Inspector Comment					
Non permitted pipe across the levee crown.

Looking northwest at the pipe across the levee crown.

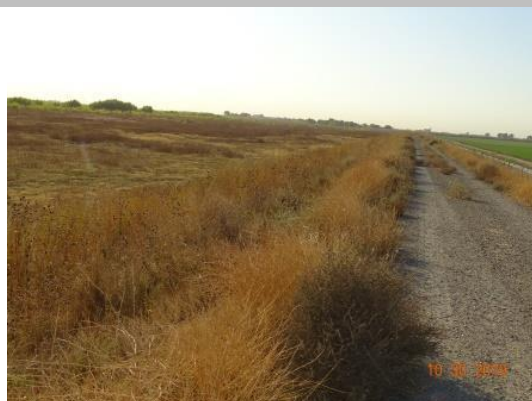
Photo 1 of 1 : FA_2019_NA0010_124_106_20191112_00203.jpg

LM Start	18.19	Rating **	U	Issue No.	106
LM End	19.28	Issue Type +	Ma	Location *	WS
Category	Earthen Levee			GPS Latitude/Longitude	
				Start	End
Item	Vegetation			37.127783 °	37.112939 °
				-120.590813 °	-120.588719 °
DWR ID	DWR_NA0010_06_f_2019_106				
Comment Code					
V1 : Control annual grass and weeds on the levee slopes and easements.					
Inspector Comment

Looking upstream along the waterside slope. (Fall 2019)

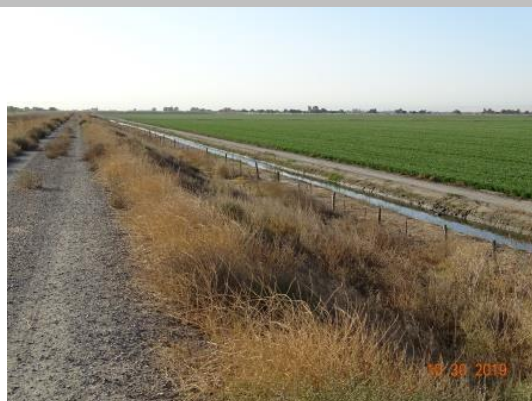
Photo 1 of 1 : FA_2019_NA0010_124_105_20191112_00205.jpg

LM Start	18.19	Rating **	U	Issue No.	105
LM End	19.41	Issue Type +	Ma	Location *	LS
Category	Earthen Levee			GPS Latitude/Longitude	
				Start	End
Item	Vegetation			37.127783 °	37.111350 °
				-120.590813 °	-120.587746 °
DWR ID	DWR_NA0010_06_f_2019_105				
Comment Code					
V1 : Control annual grass and weeds on the levee slopes and easements.					
Inspector Comment

View of the landside slope looking upstream. (Fall 2019)

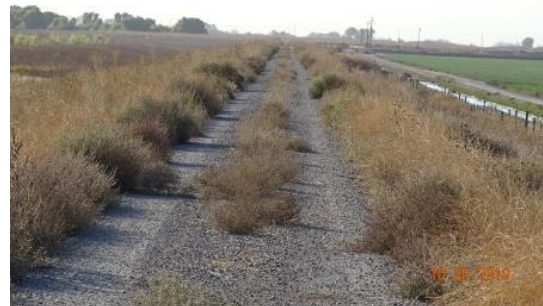
Photo 1 of 1 : FA_2019_NA0010_124_108_20191112_00206.jpg

LM Start	18.21	Rating **	M	Issue No.	108
LM End	18.76	Issue Type +	Ma	Location *	CR
Category	Earthen Levee			GPS Latitude/Longitude	
				Start	End
Item	Vegetation			37.127576 °	37.120003 °
				-120.590729 °	-120.587521 °
DWR ID	DWR_NA0010_06_f_2019_108				
Comment Code					
V9 : Keep the crown roadway free of vegetation.					
Inspector Comment

View of vegetation growing along the levee crown. (Fall 2019)

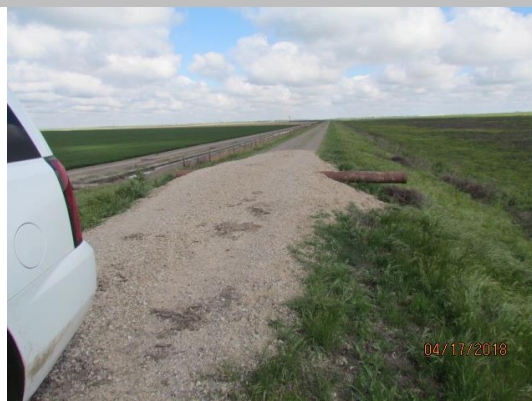
Photo 1 of 1 : FA_2019_NA0010_124_70_20190912_00017.jpg

LM Start	18.46	Rating **	U	Issue No.	70
LM End	18.46	Issue Type +	En	Location *	CR
Category	Earthen Levee			GPS Latitude/Longitude	
				Start	End
Item	Encroachments			37.124088 °	37.124088 °
				-120.589249 °	-120.589249 °
DWR ID	DWR_NA0010_06_s_2018_70				
Comment Code					
PI : Pipe					
Inspector Comment					
Landowner or farmer installed a pipe across levee crown.

Looking south at pipe across levee crown. (Spring 2018)

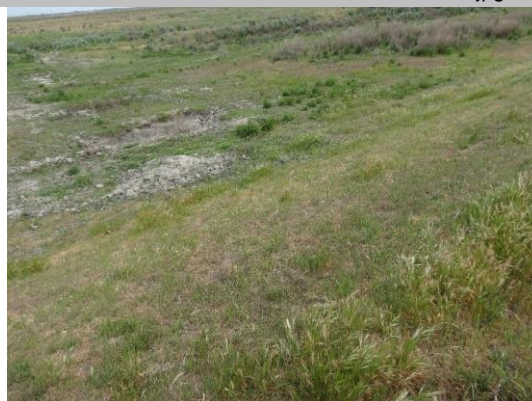
Photo 1 of 3 : UCIP_FA_2019_53191_66562.jpg

Comment Code						
Inspector Comment						
DS_ID:19888 FS_ID:53191 EP_NO: 3040 Repair Type: Urgent Crossing Status: Found UCIP Comments: 11/01/2018 Signs of pipe leakage (wet spot) visible in floodway. Crossing remains Urgent due to potential leakage along the pipe. Recommend internal inspection to determine pipe integrity through the levee. (O. Magana - DWR UCIP)07/20/2016 Same as previous inspection. Dense vegetation prevents proper inspection along floodway. (DWR UCIP - omagana)04/17/2014 Need to contact owner. Leak on waterward toe approximately 15 feet from toe. Good candidate for video or pressure test. (DWR UCIP - omagana) FIELD_STRUCT_DESC: 48-inch corrugated metal irrigation siphon pipe through the levee, 8.8 feet below the crown. Slide gate in a pipe riser on the landside (LS) slope, not the waterside (WS) slope. Concrete headwall on the LS, not the WS. Siphon extends under the channel. 24-inch corrugated metal cleanout pipe at the center of the channel with a metal plate cover. (Plans for construction of two reinforced concrete siphons across the Eastside Bypass authorized under Permit No. 3040, 1959 - Newhall Land and Farming Company). [Additional Reference(s): DWR Levee Log, 2002. USACE San Joaquin O&M Manual 601.1, 1967, (HLM 18.91)]. FS Date: 11/1/2018 12:52:00 PM

View of WS. Channel section exposed near waterward toe.

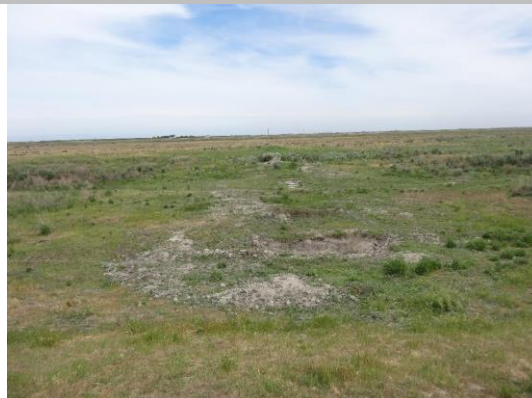
Photo 2 of 3 : UCIP_FA_2019_53191_66564.jpg

Comment Code					
Inspector Comment					
DS_ID:19888					
FS_ID:53191					
EP_NO: 3040					
Repair Type: Urgent					
Crossing Status: Found					
UCIP Comments: 11/01/2018 Signs of pipe leakage (wet spot) visible in floodway. Crossing remains Urgent due to potential leakage along the pipe. Recommend internal inspection to determine pipe integrity through the levee. (O. Magana - DWR UCIP)07/20/2016 Same as previous inspection. Dense vegetation prevents proper inspection along floodway. (DWR UCIP - omagana)04/17/2014 Need to contact owner. Leak on waterward toe approximately 15 feet from toe. Good candidate for video or pressure test. (DWR UCIP - omagana)					
FIELD_STRUCT_DESC: 48-inch corrugated metal irrigation siphon pipe through the levee, 8.8 feet below the crown. Slide gate in a pipe riser on the landside (LS) slope, not the waterside (WS) slope. Concrete headwall on the LS, not the WS. Siphon extends under the channel. 24-inch corrugated metal cleanout pipe at the center of the channel with a metal plate cover. (Plans for construction of two reinforced concrete siphons across the Eastside Bypass authorized under Permit No. 3040, 1959 - Newhall Land and Farming Company). [Additional Reference(s): DWR Levee Log, 2002. USACE San Joaquin O&M Manual 601.1, 1967, (HLM 18.91)].

Overview of Eastside Bypass.

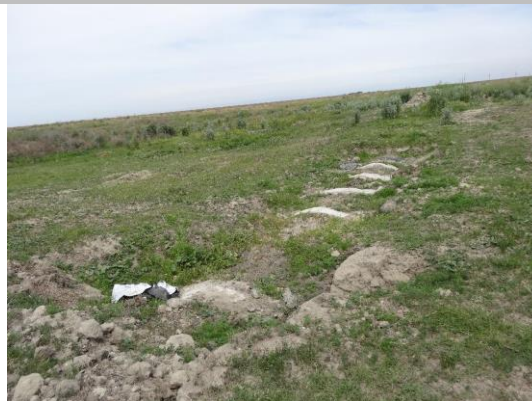
Photo 3 of 3 : UCIP_FA_2019_53191_66563.jpg

Channel sections have been excavated across Eastside Bypass.

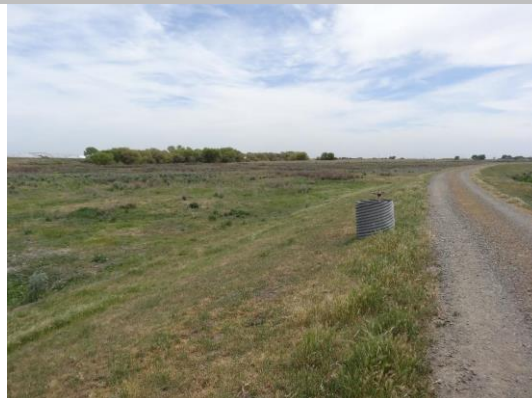
Photo 1 of 3 : UCIP_FA_2019_36687_66579.jpg

Comment Code						
Inspector Comment						
DS_ID:19889 FS_ID:36687 EP_NO: N/A Repair Type: Non-Urgent Crossing Status: Found UCIP Comments: 04/17/2014 Dense vegetation limits the inspector's visibility to identify signs of pipe failure (leaks) along the landward slope. Recommend removing vegetation along pipe alignment to conduct proper inspection of structure. (DWR UCIP - O. Magana) FIELD_STRUCT_DESC: 24-inch corrugated metal gravity drainage pipe through the levee, 10.2 feet below the crown. Slide gate in a pipe riser on the waterside (WS) slope. [Additional Reference(s): DWR Levee Log, 2002. USACE San Joaquin O&M Manual 601.1, 1967, (HLM 18.97)]. FS Date: 4/17/2014

View of waterward side.

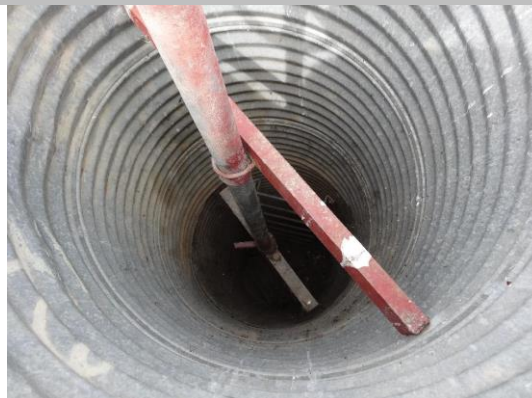
Photo 2 of 3 : UCIP_FA_2019_36687_66582.jpg

Inside view of CMP riser located on waterward slope.

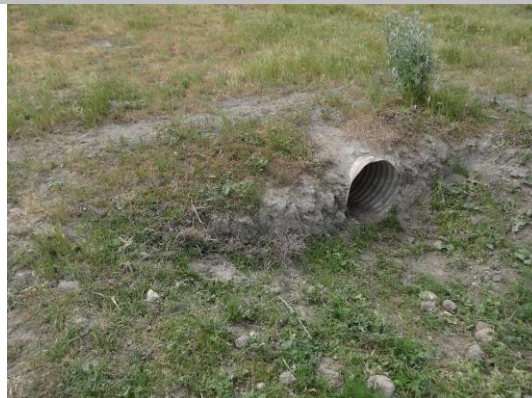
Photo 3 of 3 : UCIP_FA_2019_36687_66581.jpg

Item	DRAFT DWR UCIP LMA Responsibility			37.118178 °	37.118178 °	
				-120.586783 °	-120.586783 °	
DWR ID	19889					
Comment Code						
Inspector Comment						
DS_ID:19889						
FS_ID:36687						
EP_NO: N/A						
Repair Type: Non-Urgent						
Crossing Status: Found						
UCIP Comments: 04/17/2014 Dense vegetation limits the inspector's visibility to identify signs of pipe failure (leaks) along the landward slope. Recommend removing vegetation along pipe alignment to conduct proper inspection of structure. (DWR UCIP - O. Magana)						
FIELD_STRUCT_DESC: 24-inch corrugated metal gravity drainage pipe through the levee, 10.2 feet below the crown. Slide gate in a pipe riser on the waterside (WS) slope. [Additional Reference(s): DWR Levee Log, 2002. USACE San Joaquin O&M Manual 601.1, 1967, (HLM 18.97)].						
FS Date: 4/17/2014

Pipe daylight on waterward side.

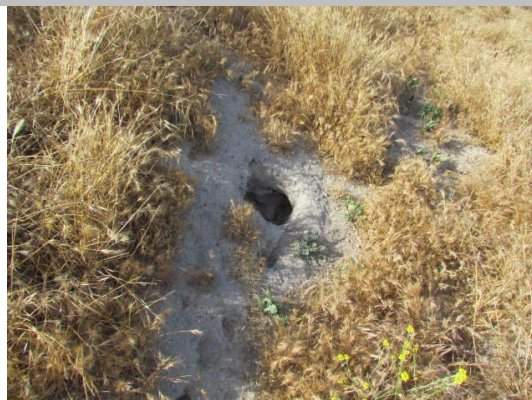
Photo 1 of 5 : FA_2019_NA0010_124_1211_20190912_00057.jpg

LM Start	19.14	Rating **	U	Issue No.	1211
LM End	19.14	Issue Type +	Ma	Location *	WS
Category	Earthen Levee			GPS Latitude/Longitude	
				Start	End
Item	Animal Control			37.114793 °	37.114793 °
				-120.587582 °	-120.587582 °
DWR ID	DWR_NA0010_06_s_2015_1211				
Comment Code					
A1 : Exterminate rodents and backfill and compact or grout burrows.					
Inspector Comment					
Several large rodent holes with more than 2 cubic feet of material were noted on the waterside slope.

Looking at rodent hole on waterward slope. Spring 2016

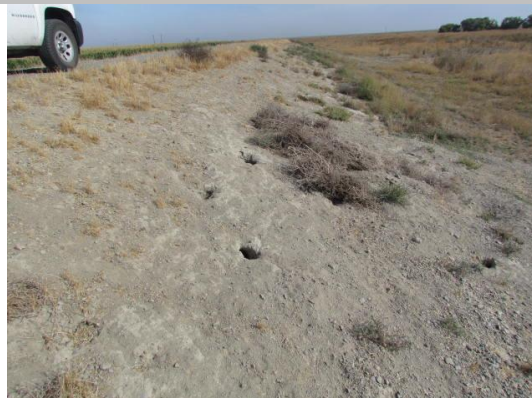
Photo 2 of 5 : FA_2019_NA0010_124_1211_20190912_00058.jpg

Looking at several rodent holes on waterward slope. (Fall 2015)

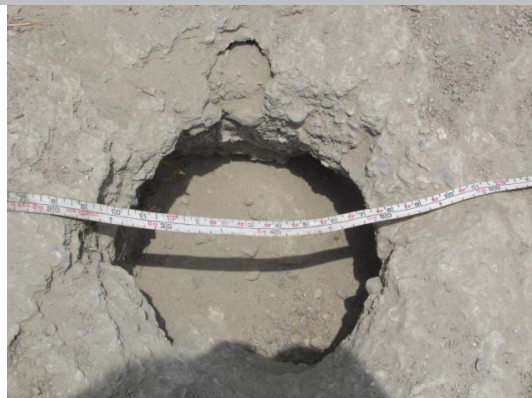
Photo 3 of 5 : FA_2019_NA0010_124_1211_20190912_00059.jpg

Looking at close-up view of large rodent hole on waterward slope. (Spring 2015)

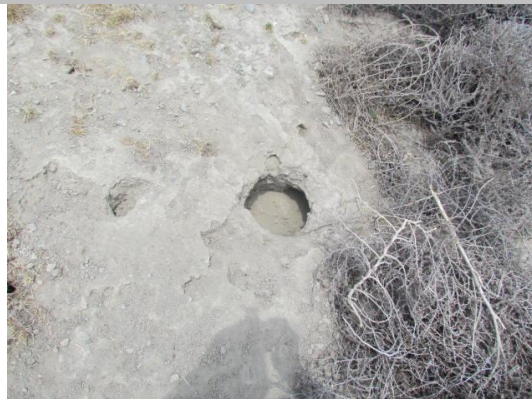
Photo 4 of 5 : FA_2019_NA0010_124_1211_20190912_00060.jpg

Looking at large rodent hole on waterward slope. Spring 2015

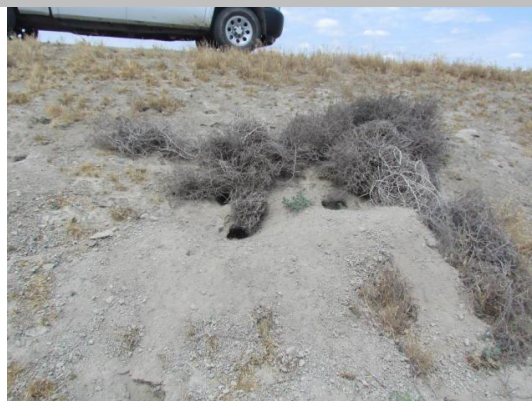
Photo 5 of 5 : FA_2019_NA0010_124_1211_20190912_00061.jpg

LM Start	19.14	Rating **	U	Issue No.	1211 (cont)
LM End	19.14	Issue Type +	Ma	Location *	WS
Category	Earthen Levee			GPS Latitude/Longitude	
				Start	End
Item	Animal Control			37.114793 °	37.114793 °
				-120.587582 °	-120.587582 °
DWR ID	DWR_NA0010_06_s_2015_1211				
Comment Code					
A1 : Exterminate rodents and backfill and compact or grout burrows.					
Inspector Comment					
Several large rodent holes with more than 2 cubic feet of material were noted on the waterside slope.

Looking west at several rodent holes on waterward slope. Spring 2015

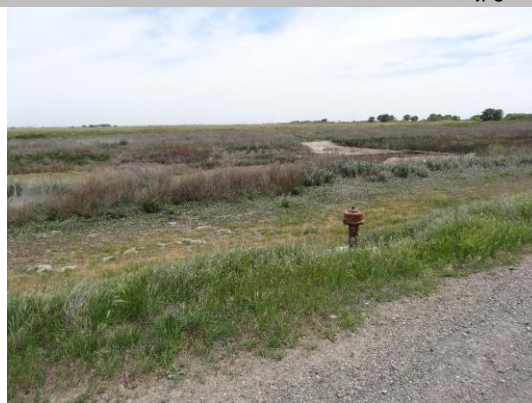
Photo 1 of 3 : UCIP_FA_2019_36688_66583.jpg

Comment Code						
Inspector Comment						
DS_ID:19890						
FS_ID:36688						
EP_NO: N/A						
Repair Type: Non-Urgent						
Crossing Status: Found						
UCIP Comments: 04/17/2014 Dense vegetation limits the inspector's visibility to identify signs of pipe failure (leaks) along the slopes. Recommend removing vegetation along pipe alignment to conduct proper inspection of structure. (DWR UCIP - O. Magana)						
FIELD_STRUCT_DESC: 48-inch corrugated metal gravity drainage pipe through the levee, 20 feet below the crown. Slide gate in a pipe riser on the waterside (WS) slope. Riprap along the landside (LS) slope. [Additional Reference(s): DWR Levee Log, 2002. USACE San Joaquin O&M Manual 601.1, 1967, (HLM 19.36)].						
FS Date: 4/17/2014

View of waterward side.

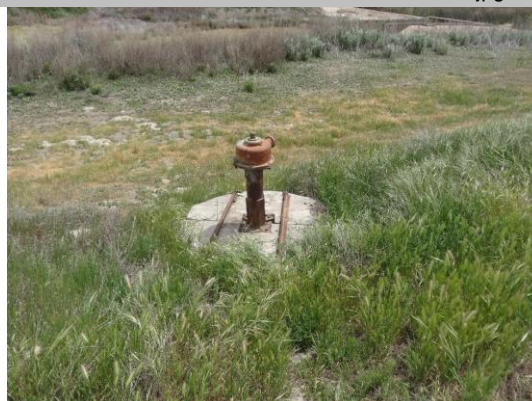
Photo 2 of 3 : UCIP_FA_2019_36688_66584.jpg

Item	DRAFT DWR UCIP LMA Responsibility			37.112902 °		37.112902 °
				-120.588751 °		-120.588751 °
DWR ID	19890					
Comment Code						
Inspector Comment						
DS_ID:19890 FS_ID:36688 EP_NO: N/A Repair Type: Non-Urgent Crossing Status: Found UCIP Comments: 04/17/2014 Dense vegetation limits the inspector's visibility to identify signs of pipe failure (leaks) along the slopes. Recommend removing vegetation along pipe alignment to conduct proper inspection of structure. (DWR UCIP - O. Magana) FIELD_STRUCT_DESC: 48-inch corrugated metal gravity drainage pipe through the levee, 20 feet below the crown. Slide gate in a pipe riser on the waterside (WS) slope. Riprap along the landside (LS) slope. [Additional Reference(s): DWR Levee Log, 2002. USACE San Joaquin O&M Manual 601.1, 1967, (HLM 19.36)]. FS Date: 4/17/2014

Riser located on waterward slope.

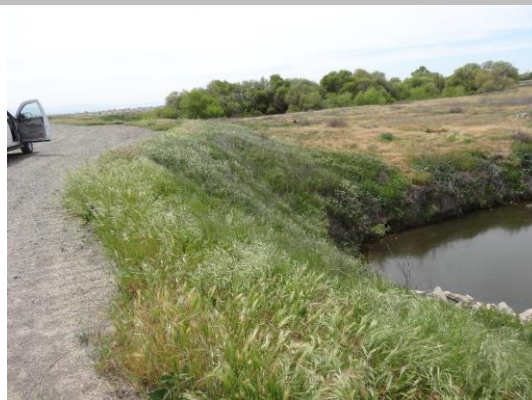
Photo 3 of 3 : UCIP_FA_2019_36688_66586.jpg

View of landward slope.

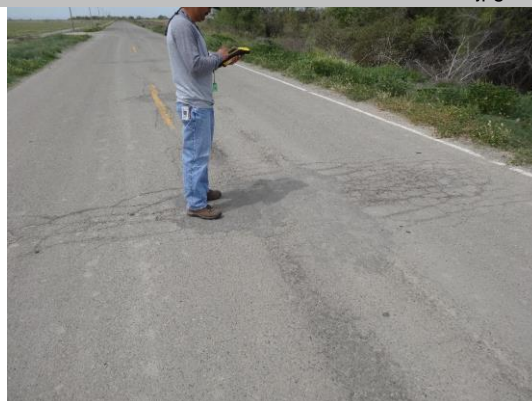
Photo 1 of 3 : UCIP_FA_2019_36689_66591.jpg

Comment Code						
Inspector Comment						
DS_ID:19891						
FS_ID:36689						
EP_NO: N/A						
Repair Type: Non-Urgent						
Crossing Status: Found						
UCIP Comments: 04/17/2014 Dense vegetation limits the inspector's visibility to identify signs of pipe failure (leaks) along the slopes. Recommend removing vegetation along pipe alignment to conduct proper inspection of structure. (DWR UCIP - O. Magana)						
FIELD_STRUCT_DESC: 30-inch by 30-inch reinforced concrete box gravity drainage culvert through the levee, 14 feet below the crown. Flap gate on the waterside (WS) end. [Additional Reference(s): DWR Levee Log, 2002. USACE San Joaquin O&M Manual 601.1, 1967, (HLM 19.85)].						
FS Date: 4/17/2014

Overview of levee crown looking downstream.

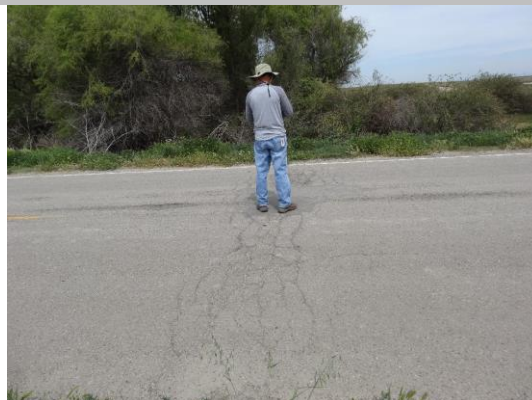
Photo 2 of 3 : UCIP_FA_2019_36689_66592.jpg

View of levee crown at crossing.

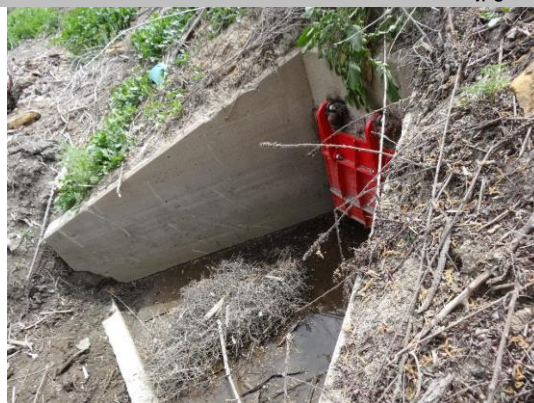
Photo 3 of 3 : UCIP_FA_2019_36689_66590.jpg

Item	DRAFT DWR UCIP LMA Responsibility			37.113304 °	37.113304 °	
				-120.579102 °	-120.579102 °	
DWR ID	19891					
Comment Code						
Inspector Comment						
DS_ID:19891						
FS_ID:36689						
EP_NO: N/A						
Repair Type: Non-Urgent						
Crossing Status: Found						
UCIP Comments: 04/17/2014 Dense vegetation limits the inspector's visibility to identify signs of pipe failure (leaks) along the slopes. Recommend removing vegetation along pipe alignment to conduct proper inspection of structure. (DWR UCIP - O. Magana)						
FIELD_STRUCT_DESC: 30-inch by 30-inch reinforced concrete box gravity drainage culvert through the levee, 14 feet below the crown. Flap gate on the waterside (WS) end. [Additional Reference(s): DWR Levee Log, 2002. USACE San Joaquin O&M Manual 601.1, 1967, (HLM 19.85)].						
FS Date: 4/17/2014

View of "U" concrete headwall located on waterward side.

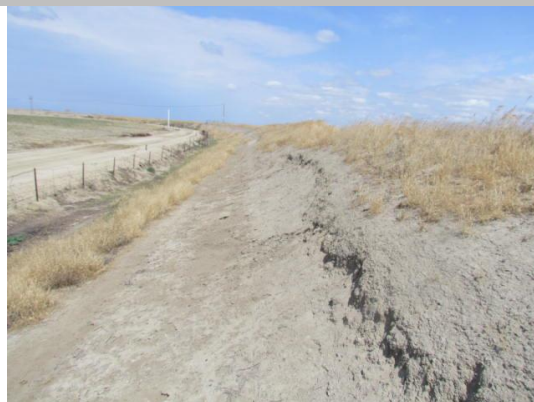
Photo 1 of 2 : FA_2019_NA0010_124_1209_20190912_00055.jpg

LM Start	20.79	Rating **	M	Issue No.	1209
LM End	21.10	Issue Type +	Ma	Location *	LS
Category	Earthen Levee			GPS Latitude/Longitude	
				Start	End
Item	Erosion / Bank Caving			37.113107 °	37.109735 °
				-120.563782 °	-120.560079 °
DWR ID	DWR_NA0010_06_s_2015_1209				
Comment Code					
E1 : Note and monitor erosion site.					
Inspector Comment					
Erosion on landside slope greater than 3 inches. Erosion caused by livestock.

Looking north at livestock erosion on landward slope.

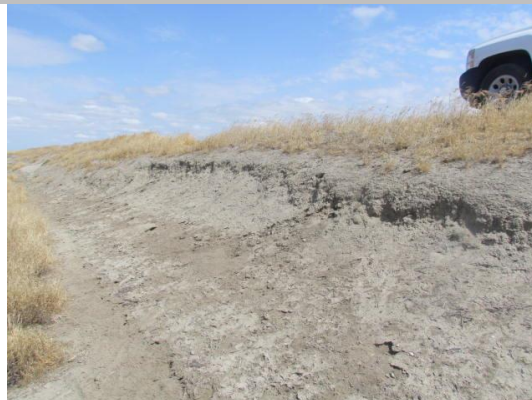
Photo 2 of 2 : FA_2019_NA0010_124_1209_20190912_00056.jpg

LM Start	20.79	Rating **	M	Issue No.	1209 (cont)	
LM End	21.10	Issue Type +	Ma	Location *	LS	
Category	Earthen Levee			GPS Latitude/Longitude		
				Start		End
Item	Erosion / Bank Caving			37.113107 °		37.109735 °
				-120.563782 °		-120.560079 °
DWR ID	DWR_NA0010_06_s_2015_1209					
Comment Code						
E1 : Note and monitor erosion site.						
Inspector Comment						
Erosion on landside slope greater than 3 inches. Erosion caused by livestock.

Looking northeast at livestock erosion on landward slope.

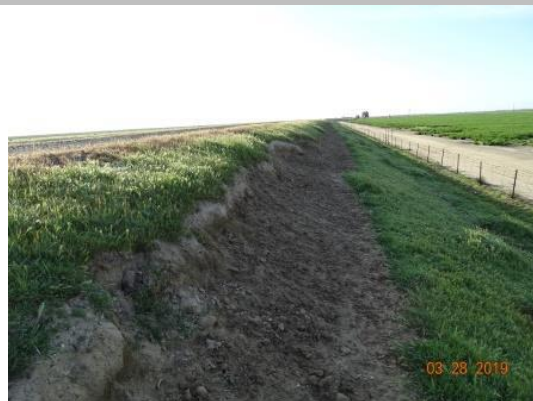
Photo 1 of 3 : FA_2019_NA0010_124_107_20190912_00038.jpg

LM Start	21.71	Rating **	M	Issue No.	107
LM End	21.78	Issue Type +	Ma	Location *	LS
Category	Earthen Levee			GPS Latitude/Longitude	
				Start	End
Item	Erosion / Bank Caving			37.102844°	37.102002°
				-120.553160°	-120.552314°
DWR ID	DWR_NA0010_06_f_2018_107				
Comment Code					
E1 : Note and monitor erosion site.					
Inspector Comment					
Erosion into levee prism due to livestock activities.

View of erosion in landside levee prism. (Spring 2019)

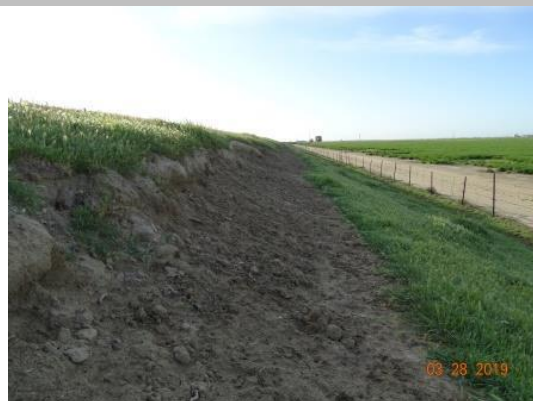
Photo 2 of 3 : FA_2019_NA0010_124_107_20190912_00039.jpg

View of erosion looking upstream. (Spring 2019)

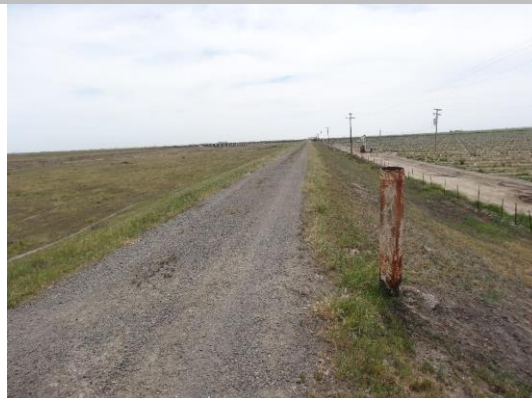
Photo 1 of 3 : UCIP_FA_2019_34010_61871.jpg

Comment Code						
Inspector Comment						
DS_ID:19879 FS_ID:34010 EP_NO: 13638 Repair Type: Non-Urgent Crossing Status: Found UCIP Comments: 04/17/2014 Need to contact owner to determine status. Crossing has been modified. (DWR UCIP - O. Magana) FIELD_STRUCT_DESC: 16-inch coated steel irrigation discharge pipe through the levee, 3.5 feet below the crown. Cutoff wall around the pipe at the center of the levee. Pump on the waterside (WS). Siphon breaker on the landside (LS) shoulder. Intake trench on the WS. (Plans to install a pump with a 16-inch pipeline over the levee authorized under Permit No. 13638, 1983 - Hamonds Ranch). [Additional Reference(s): DWR Levee Log, 2002]. FS Date: 4/17/2014

Overview of levee crown at crossing.

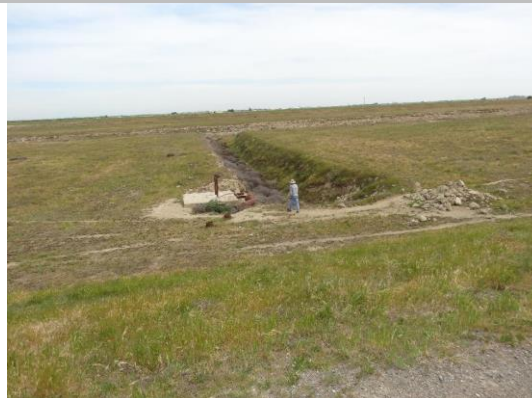
Photo 2 of 3 : UCIP_FA_2019_34010_61870.jpg

View of waterward side.

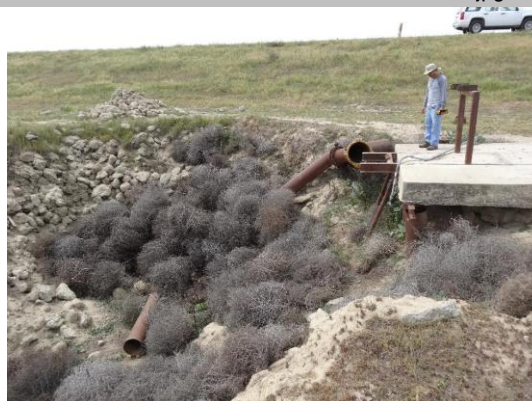
Photo 3 of 3 : UCIP_FA_2019_34010_61875.jpg

Item	DRAFT DWR UCIP Field Study			37.077406 °		37.077406 °
				-120.525938 °		-120.525938 °
DWR ID	19879					
Comment Code						
Inspector Comment						
DS_ID:19879 FS_ID:34010 EP_NO: 13638 Repair Type: Non-Urgent Crossing Status: Found UCIP Comments: 04/17/2014 Need to contact owner to determine status. Crossing has been modified. (DWR UCIP - O. Magana) FIELD_STRUCT_DESC: 16-inch coated steel irrigation discharge pipe through the levee, 3.5 feet below the crown. Cutoff wall around the pipe at the center of the levee. Pump on the waterside (WS). Siphon breaker on the landside (LS) shoulder. Intake trench on the WS. (Plans to install a pump with a 16-inch pipeline over the levee authorized under Permit No. 13638, 1983 - Hamonds Ranch). [Additional Reference(s): DWR Levee Log, 2002]. FS Date: 4/17/2014

Concrete pad with abandoned support frame located on waterward side.

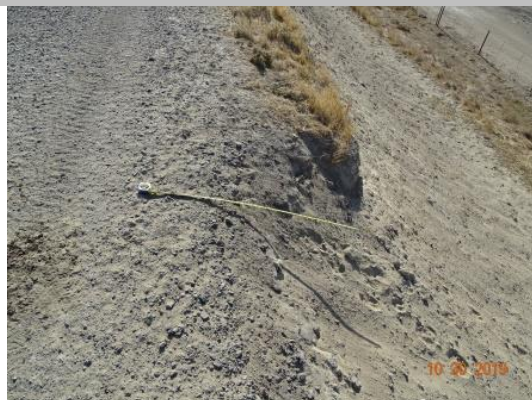
Photo 1 of 4 : FA_2019_NA0010_124_5_20191112_00209.jpg

LM Start	24.51	Rating **	U	Issue No.	5
LM End	25.01	Issue Type +	Ma	Location *	LS
Category	Earthen Levee			GPS Latitude/Longitude	
				Start	End
Item	Slope Stability			37.072048 °	37.066501 °
				-120.520180 °	-120.514193 °
DWR ID	DWR_NA0010_06_s_2012_5				
Comment Code					
S2 : Repair the levee slope damaged by foot traffic and prevent access where possible.					
Inspector Comment					
Landside erosion and slope instability caused by livestock extends into levee crown. At the worst locations erosion extends 2.5 feet to 3 feet from the shoulder into the crown.

Representative view of landside erosion due to livestock traffic. (Fall 2019)

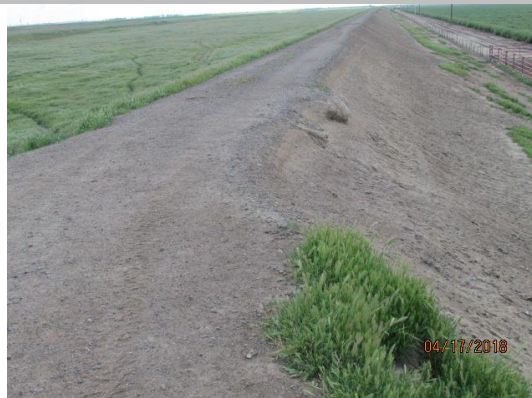
Photo 2 of 4 : FA_2019_NA0010_124_5_20190912_00006.jpg

Looking north at livestock erosion into landward shoulder. (Spring 2018)

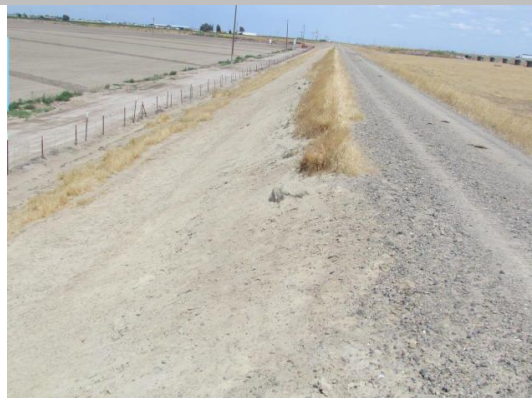
Photo 3 of 4 : FA_2019_NA0010_124_5_20190912_00007.jpg

Looking north at livestock erosion on landward slope. (Spring 2015)

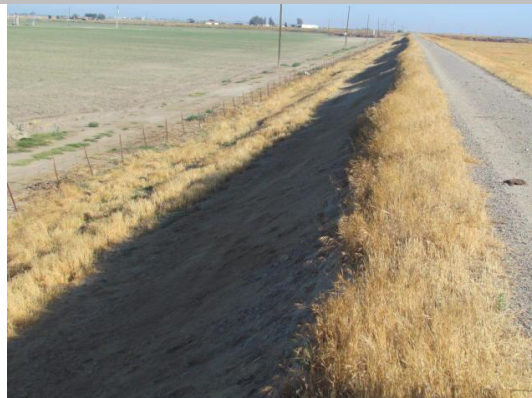
Photo 4 of 4 : FA_2019_NA0010_124_5_20190912_00008.jpg

Looking north at livestock erosion on landward slope. (Spring 2014)

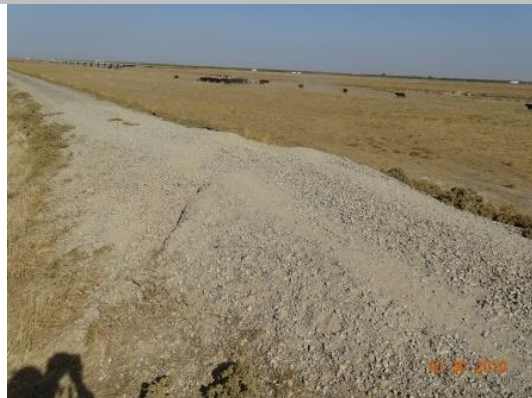
Photo 1 of 2 : FA_2019_NA0010_124_83_20191112_00210.jpg

LM Start	24.98	Rating **	M	Issue No.	83
LM End	24.98	Issue Type +	En	Location *	CR
Category	Earthen Levee			GPS Latitude/Longitude	
				Start	End
Item	Encroachments			37.066893 °	37.066893 °
				-120.514623 °	-120.514623 °
DWR ID	DWR_NA0010_06_f_2017_83				
Comment Code					
PI : Pipe					
Inspector Comment					
Temporary pipe has been removed but the material used to ramp over the pipe was left on the levee crown.

View of material left on levee crown used to ramp over the temporary pipe. (Fall 2019)

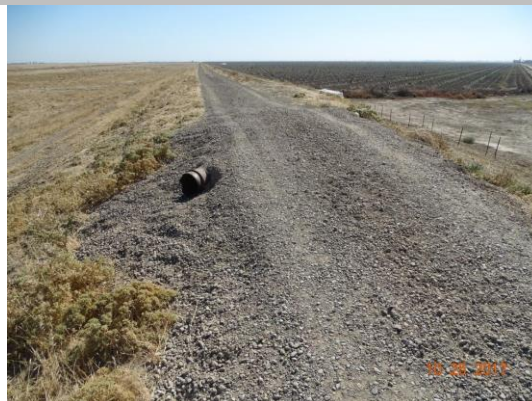
Photo 2 of 2 : FA_2019_NA0010_124_83_20190912_00027.jpg

Looking southeast at the pipe on the levee crown. (Fall 2017)

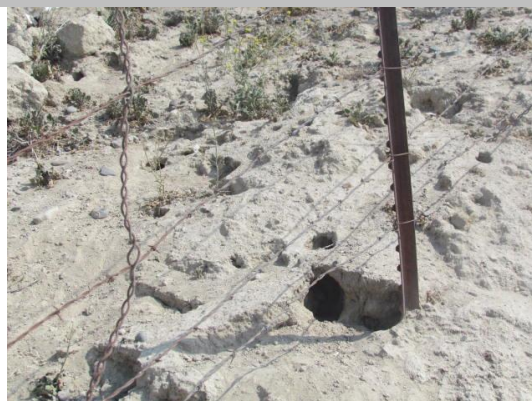
Photo 1 of 1 : FA_2019_NA0010_124_1208_20190912_00054.jpg

LM Start	26.13	Rating **	M	Issue No.	1208
LM End	26.13	Issue Type +	Ma	Location *	LS
Category	Earthen Levee			GPS Latitude/Longitude	
				Start	End
Item	Animal Control			37.054222 °	37.054222 °
				-120.500862 °	-120.500862 °
DWR ID	DWR_NA0010_06_s_2015_1208				
Comment Code					
A1 : Exterminate rodents and backfill and compact or grout burrows.					
Inspector Comment					
Noted several rodent holes next to and within rock revetment on landside slope.

Rodent holes on landward slope.

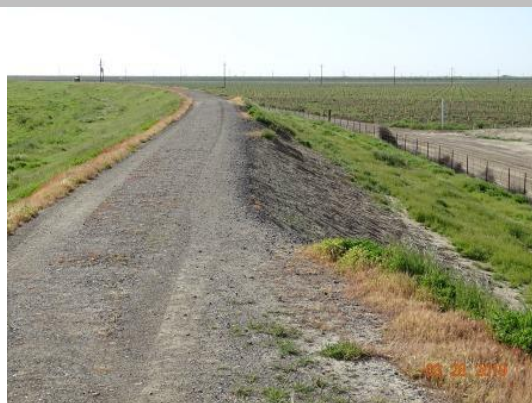
Photo 1 of 3 : FA_2019_NA0010_124_3_20190912_00003.jpg

LM Start	27.43	Rating **	M	Issue No.	3
LM End	27.97	Issue Type +	Ma	Location *	LS
Category	Earthen Levee			GPS Latitude/Longitude	
				Start	End
Item	Slope Stability			37.036955 °	37.032887 °
				-120.484395 °	-120.481225 °
DWR ID	DWR_NA0010_06_s_2012_3				
Comment Code					
S2 : Repair the levee slope damaged by foot traffic and prevent access where possible.					
Inspector Comment					
Landside erosion and slope instability caused by livestock. Erosion greater than 3" in depth on landside slope. Levee crown has narrowed within this reach.

Looking south along landside slope. (Spring 2019)

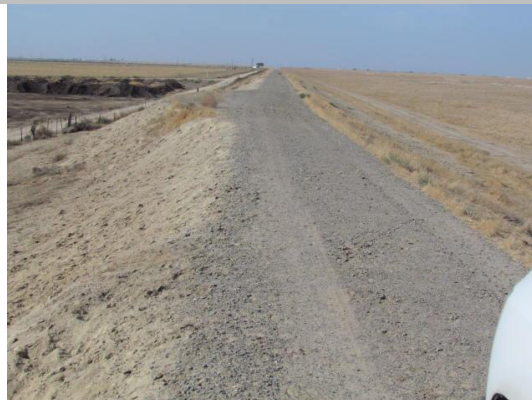
Photo 2 of 3 : FA_2019_NA0010_124_3_20190912_00004.jpg

Looking north at livestock erosion on landward slope. Fall 2015

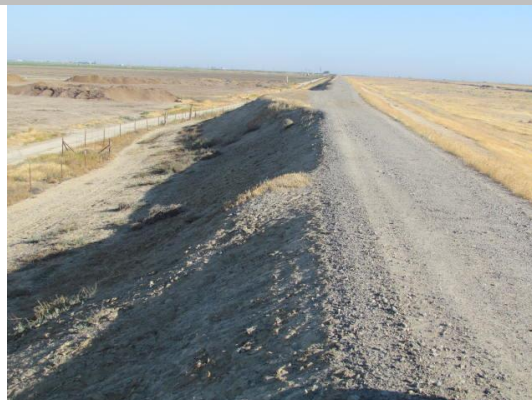
Photo 3 of 3 : FA_2019_NA0010_124_3_20190912_00005.jpg

Looking north at livestock erosion on landward slope. (Spring 2013)

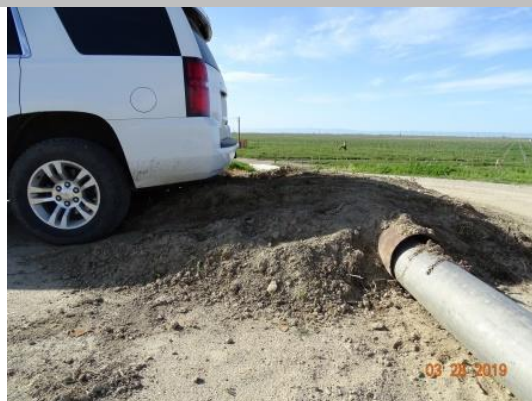
Photo 2 of 3 : FA_2019_NA0010_124_110_20190912_00042.jpg

LM Start	28.43	Rating **	U	Issue No.	110 (cont)
LM End	28.43	Issue Type +	En	Location *	CR
Category	Earthen Levee			GPS Latitude/Longitude	
				Start	End
Item	Encroachments			37.029935 °	37.029935 °
				-120.474057 °	-120.474057 °
DWR ID	DWR_NA0010_06_s_2019_110				
Comment Code					
PI : Pipe					
Inspector Comment					
Landowner has installed a temporary pipe across the levee. The size of the pipe and short ramp increases the chances of vehicles bottoming out.

View of pipe crossing looking West. (Spring 2019)

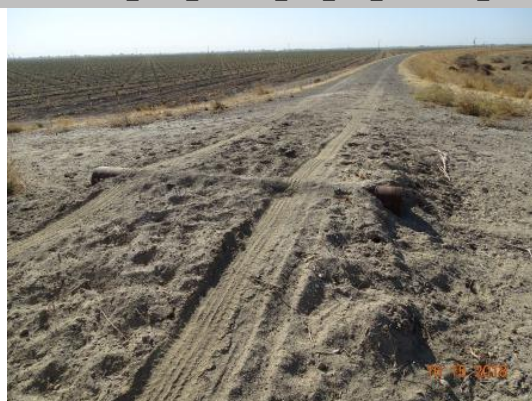
Photo 3 of 3 : FA_2019_NA0010_124_110_20190912_00043.jpg

Landowner has installed a temporary pipe across levee crown. (Fall 2018)

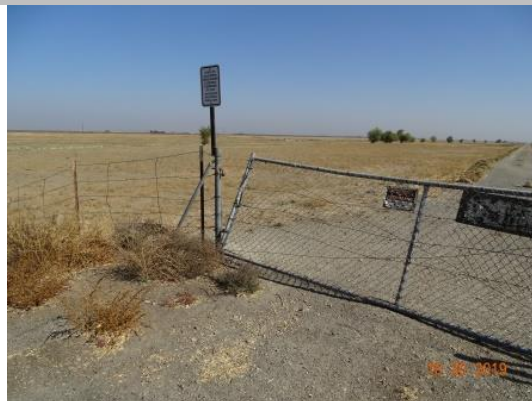
Photo 1 of 1 : FA_2019_NA0010_124_122_20191112_00211.jpg

LM Start	28.47	Rating **	U	Issue No.	122
LM End	28.47	Issue Type +	Ma	Location *	CR
Category	Earthen Levee			GPS Latitude/Longitude	
				Start	End
Item	Repair Gates			37.029933 °	37.029933 °
				-120.473445 °	-120.473445 °
DWR ID	DWR_NA0010_06_f_2019_122				
Comment Code					
Inspector Comment					
The gate has sheared off the top hinge and should be replaced.

View of broken gate at LM 28.47 looking upstream. (Fall 2019)

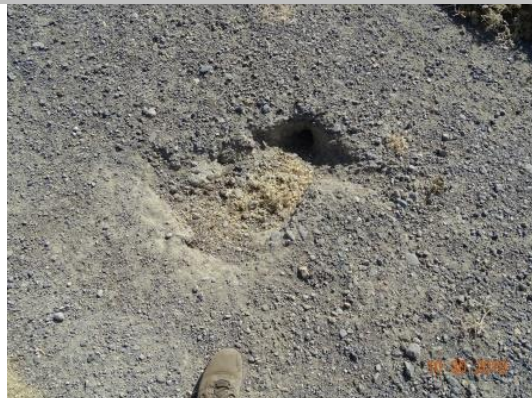
Photo 1 of 1 : FA_2019_NA0010_124_19_20191115_00216.jpg

LM Start	28.47	Rating **	M	Issue No.	19
LM End	28.83	Issue Type +	Ma	Location *	LS
Category	Earthen Levee			GPS Latitude/Longitude	
				Start	End
Item	Animal Control			37.029937 °	37.030108 °
				-120.473384 °	-120.466867 °
DWR ID	DWR_NA0010_06_s_2015_19				
Comment Code					
A3 : No rodents visible, but rodent burrows visible; need to backfill and compact or grout burrows.					
Inspector Comment					
Rodent burrows are also on the crown.

View of rodent burrow in the levee crown. (Fall 2019)

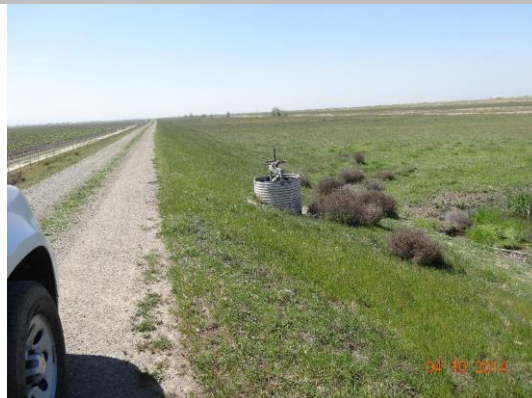
Photo 1 of 3 : UCIP_FA_2019_39886_66600.jpg

Comment Code					
Inspector Comment					
DS_ID:19881 FS_ID:39886 EP_NO: N/A Repair Type: Non-Urgent Crossing Status: Found UCIP Comments: 04/10/2014 Dense vegetation limits the inspector's visibility to identify signs of pipe failure (leaks) along the slopes. Recommend removing vegetation along pipe alignment to conduct proper inspection of structure. (DWR UCIP - O. Magana) FIELD_STRUCT_DESC: 36-inch corrugated metal gravity irrigation pipe through the levee, 12.4 feet below the crown. Slide gate in a 48-inch corrugated metal pipe (CMP) riser on the waterside (WS) slope. Concrete U-shaped headwall on each end. Cobble pad on the landside (LS). [Additional Reference(s): DWR Levee Log, 2002. USACE San Joaquin O&M Manual 601.1, 1967, (HLM 29.34)]. FS Date: 4/10/2014

View of waterward side--slide gate inside CMP riser located on waterward slope.

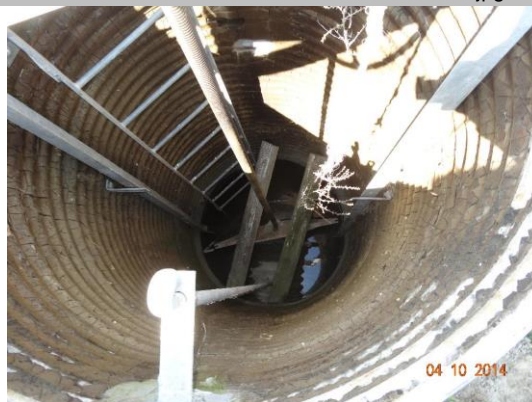
Photo 2 of 3 : UCIP_FA_2019_39886_66603.jpg

Inside view of CMP riser located on waterward slope.

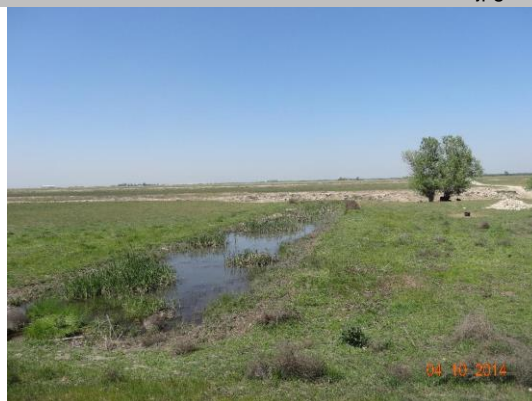
Photo 3 of 3 : UCIP_FA_2019_39886_66599.jpg

Comment Code					
Inspector Comment					
DS_ID:19881 FS_ID:39886 EP_NO: N/A Repair Type: Non-Urgent Crossing Status: Found UCIP Comments: 04/10/2014 Dense vegetation limits the inspector's visibility to identify signs of pipe failure (leaks) along the slopes. Recommend removing vegetation along pipe alignment to conduct proper inspection of structure. (DWR UCIP - O. Magana) FIELD_STRUCT_DESC: 36-inch corrugated metal gravity irrigation pipe through the levee, 12.4 feet below the crown. Slide gate in a 48-inch corrugated metal pipe (CMP) riser on the waterside (WS) slope. Concrete U-shaped headwall on each end. Cobble pad on the landside (LS). [Additional Reference(s): DWR Levee Log, 2002. USACE San Joaquin O&M Manual 601.1, 1967, (HLM 29.34)]. FS Date: 4/10/2014

View of waterward side.

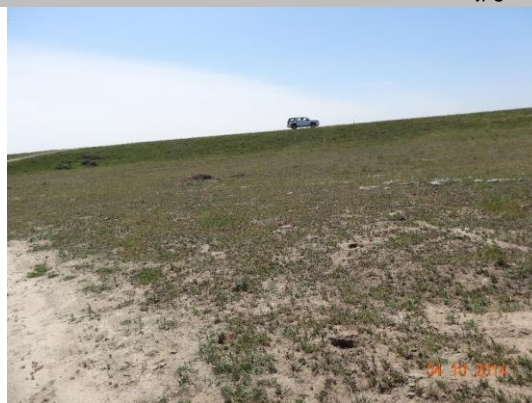
Photo 1 of 3 : UCIP_FA_2019_36693_66607.jpg

Comment Code					
Inspector Comment					
DS_ID:19882					
FS_ID:36693					
EP_NO: N/A					
Repair Type: Non-Urgent					
Crossing Status: Found					
UCIP Comments: 04/10/2014 Altered crossing--steel pipe section on landward side and concrete pipe section on waterward side. Joints on waterward side seperated. Need to contact owner to determine status. (DWR UCIP - O. Magana)					
FIELD_STRUCT_DESC: [Rodunder Siphon Structure] 48-inch reinforced concrete irrigation siphon pipe through the levee, 14.5 feet below the crown. Concrete U-shaped headwall on the outlet structure on the landside (LS) end. Slide gate mounted on the headwall.					
[Additional Reference(s): DWR Levee Log, 2002. USACE San Joaquin O&M Manual 601.1, 1967, (HLM 30.27)].					
FS Date: 4/10/2014

Overview of waterward side.

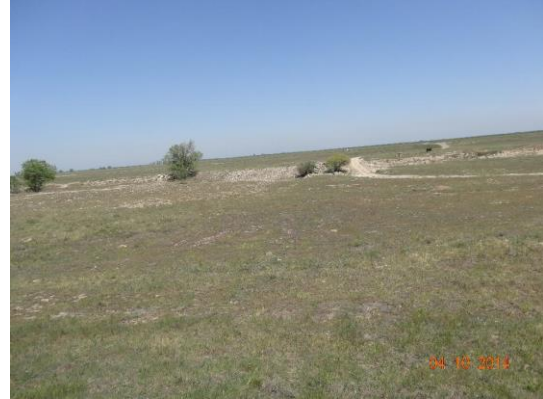
Photo 2 of 3 : UCIP_FA_2019_36693_66604.jpg

Comment Code					
Inspector Comment					
DS_ID:19882 FS_ID:36693 EP_NO: N/A Repair Type: Non-Urgent Crossing Status: Found UCIP Comments: 04/10/2014 Altered crossing--steel pipe section on landward side and concrete pipe section on waterward side. Joints on waterward side seperated. Need to contact owner to determine status. (DWR UCIP - O. Magana) FIELD_STRUCT_DESC: [Rodunder Siphon Structure] 48-inch reinforced concrete irrigation siphon pipe through the levee, 14.5 feet below the crown. Concrete U-shaped headwall on the outlet structure on the landside (LS) end. Slide gate mounted on the headwall. [Additional Reference(s): DWR Levee Log, 2002. USACE San Joaquin O&M Manual 601.1, 1967, (HLM 30.27)]. FS Date: 4/10/2014

Overview of Eastside Bypass at crossing.

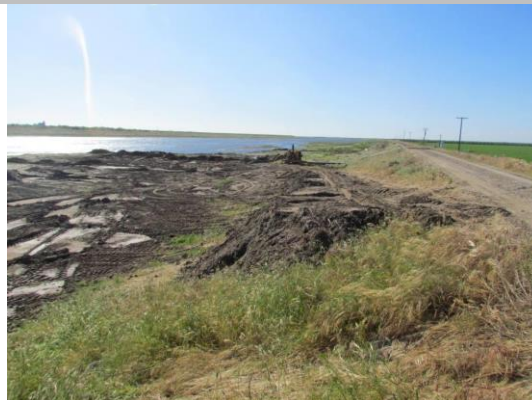
Photo 1 of 1 : FA_2019_NA0010_124_80_20190912_00024.jpg

LM Start	31.10	Rating **	U	Issue No.	80
LM End	31.10	Issue Type +	En	Location *	WS
Category	Earthen Levee			GPS Latitude/Longitude	
				Start	End
Item	Encroachments			37.017907 °	37.017907 °
				-120.434970 °	-120.434970 °
DWR ID	DWR_NA0010_06_s _ 2017_80				
Comment Code					
RA : Ramp					
Inspector Comment					
Farmer installed ramp on waterside slope.

Looking upstream at ramp on waterward slope.

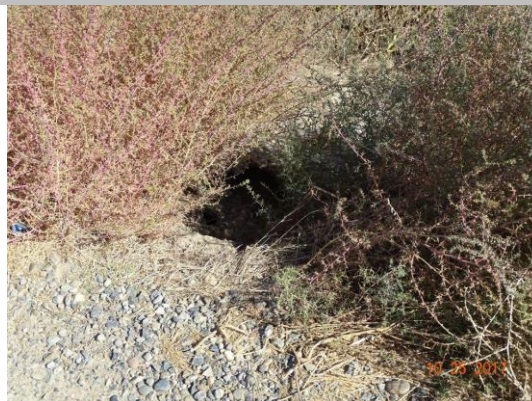
Photo 1 of 1 : FA_2019_NA0010_124_82_20190912_00026.jpg

LM Start	31.14	Rating **	U	Issue No.	82
LM End	31.14	Issue Type +	Ma	Location *	WS
Category	Earthen Levee			GPS Latitude/Longitude	
				Start	End
Item	Animal Control			37.017445 °	37.017445 °
				-120.434713 °	-120.434713 °
DWR ID	DWR_NA0010_06_f_2017_82				
Comment Code					
A3 : No rodents visible, but rodent burrows visible; need to backfill and compact or grout burrows.					
Inspector Comment

Looking east at the waterside slope.

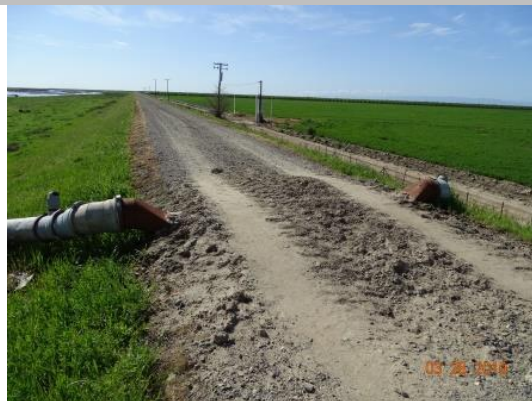
Photo 1 of 1 : FA_2019_NA0010_124_128_20190912_00048.jpg

LM Start	31.18	Rating **	M	Issue No.	128
LM End	31.18	Issue Type +	En	Location *	CR
Category	Earthen Levee			GPS Latitude/Longitude	
				Start	End
Item	Encroachments			37.016932 °	37.016932 °
				-120.434346 °	-120.434346 °
DWR ID	DWR_NA0010_06_s_2019_128				
Comment Code					
PI : Pipe					
Inspector Comment					
Temporary pipe is installed across levee crown by landowner.

View of pipe crossing looking upstream. (Spring 2019)
