**Flood Control Project Maintenance
Levee Inspections**

Fall 2019 Levee Maintenance Deficiency Summary Report

San Joaquin River Basin

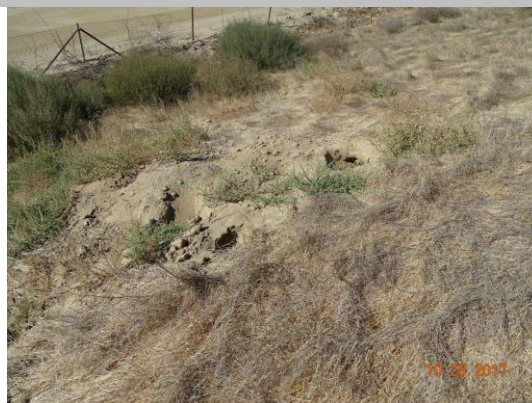
Photo 1 of 1 : FA_2019_NA0010_124_81_20190912_00025.jpg

LM Start	32.00	Rating **	U	Issue No.	81
LM End	32.00	Issue Type +	Ma	Location *	LS
Category	Earthen Levee			GPS Latitude/Longitude	
				Start	End
Item	Animal Control			37.007007 °	37.007007 °
				-120.426179 °	-120.426179 °
DWR ID	DWR_NA0010_06_f_2017_81				
Comment Code					
A3 : No rodents visible, but rodent burrows visible; need to backfill and compact or grout burrows.					
Inspector Comment

Looking west at the landside slope.

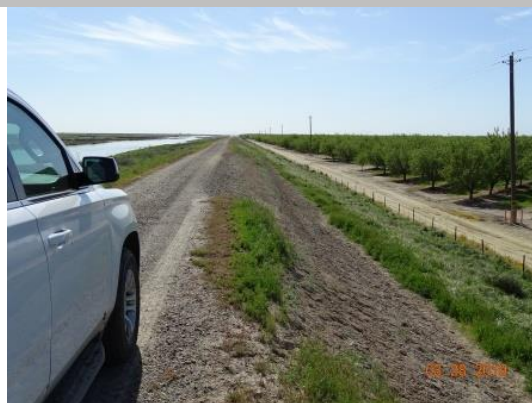
Photo 1 of 1 : FA_2019_NA0010_124_129_20190912_00049.jpg

LM Start	32.62	Rating **	M	Issue No.	129
LM End	36.26	Issue Type +	Ma	Location *	LS
Category	Earthen Levee			GPS Latitude/Longitude	
				Start	End
Item	Slope Stability			37.000645 °	36.974414 °
				-120.418415 °	-120.366969 °
DWR ID	DWR_NA0010_06_s_2019_129				
Comment Code					
S2 : Repair the levee slope damaged by foot traffic and prevent access where possible.					
Inspector Comment					
Slope damage from livestock. Damage is beginning to erode into levee crown.

Erosion from animal activity along the landside slope. (Spring 2019)

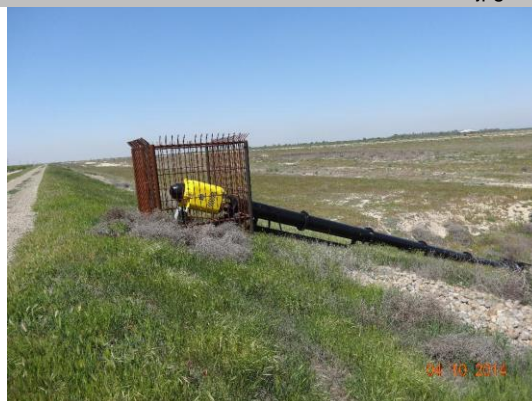
Photo 1 of 3 : UCIP_FA_2019_46183_61898.jpg

Comment Code					
Inspector Comment					
DS_ID:19883 FS_ID:46183 EP_NO: 6416A Repair Type: Non-Urgent Crossing Status: Found UCIP Comments: 04/10/2014 Crossing updated--need to contact owner to determine permit issued by CVFPB for authorized changes. (DWR UCIP - O. Magana) FIELD_STRUCT_DESC: 20-inch (not 18 inch as mentioned in the DS study) coated steel drainage discharge pipe through the levee, 3.9 feet below the crown. Electrical conduit through the levee. Cutoff wall around pipe at centerline of levee. Capped with a welded plate on the landside (LS) end. Siphon breaker on the apex of the pipe on the LS shoulder. Slant pump on the waterside (WS) slope. (To revise plans for a slant pump and an 18-inch steel pipe through the levee authorized under Permit No. 6416-A, 1975 - Triangle T. Ranch, Inc.). [Additional Reference(s): DWR Levee Log, 2002]. FS Date: 4/10/2014

View of waterward side--pipe and pump fenced off on waterward slope.

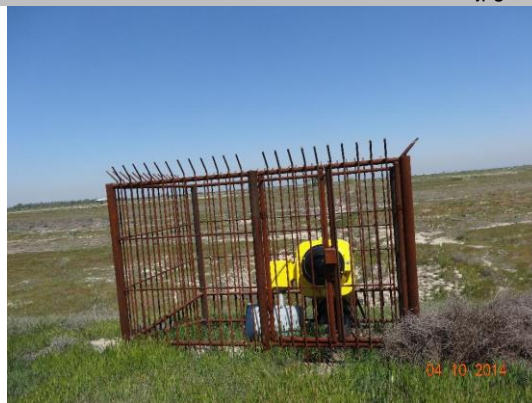
Photo 2 of 3 : UCIP_FA_2019_46183_61902.jpg

Electrical conduit visible on waterward slope.

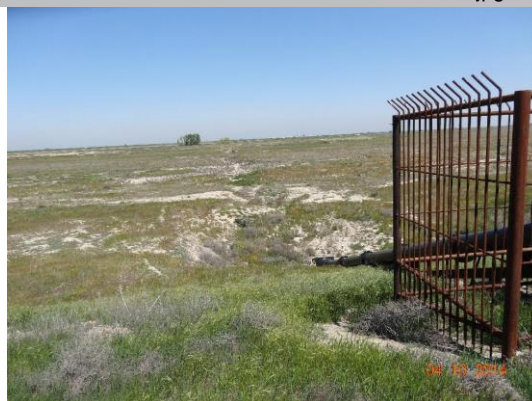
Photo 3 of 3 : UCIP_FA_2019_46183_61903.jpg

Item	DRAFT DWR UCIP Field Study			36.995672 °	36.995672 °	
				-120.412919 °	-120.412919 °	
DWR ID	19883					
Comment Code						
Inspector Comment						
DS_ID:19883 FS_ID:46183 EP_NO: 6416A Repair Type: Non-Urgent Crossing Status: Found UCIP Comments: 04/10/2014 Crossing updated--need to contact owner to determine permit issued by CVFPB for authorized changes. (DWR UCIP - O. Magana) FIELD_STRUCT_DESC: 20-inch (not 18 inch as mentioned in the DS study) coated steel drainage discharge pipe through the levee, 3.9 feet below the crown. Electrical conduit through the levee. Cutoff wall around pipe at centerline of levee. Capped with a welded plate on the landside (LS) end. Siphon breaker on the apex of the pipe on the LS shoulder. Slant pump on the waterside (WS) slope. (To revise plans for a slant pump and an 18-inch steel pipe through the levee authorized under Permit No. 6416-A, 1975 - Triangle T. Ranch, Inc.). [Additional Reference(s): DWR Levee Log, 2002]. FS Date: 4/10/2014

View of Eastside Bypass.

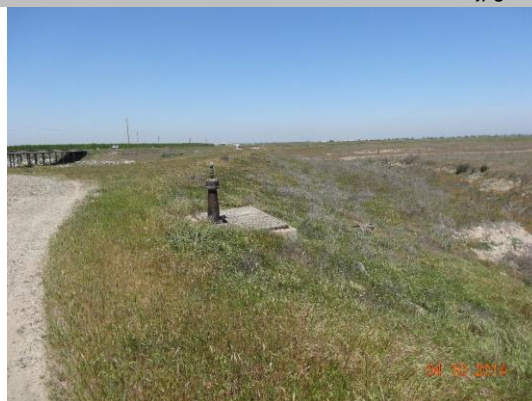
Photo 1 of 3 : UCIP_FA_2019_39481_66628.jpg

Comment Code					
Inspector Comment					
DS_ID:19813 FS_ID:39481 EP_NO: N/A Repair Type: Non-Urgent Crossing Status: Found UCIP Comments: 04/10/2014 Dense vegetation limits the inspector's visibility to identify signs of pipe failure (leaks) along the slope. Recommend removing vegetation along pipe alignment to conduct proper inspection of structure and appurtenances. High vegetation along crossing alignment--recommend removing vegetation along pipe crossing. (DWR UCIP - O. Magana) FIELD_STRUCT_DESC: [Fresno River Irrigation Structure] 48-inch by 72-inch reinforced concrete box gravity irrigation culvert through the levee, 15.1 feet below the crown. Slide gate in a concrete riser in the waterside (WS) slope. Concrete U-shaped headwall on each end. Landside (LS) channel cobble revetted for 8 feet. [Additional Reference(s): DWR Levee Log, 2002. USACE San Joaquin O&M Manual 601.1, 1967, (HLM 35.33)]. FS Date: 4/10/2014

View of waterward side--slide gate inside concrete box.

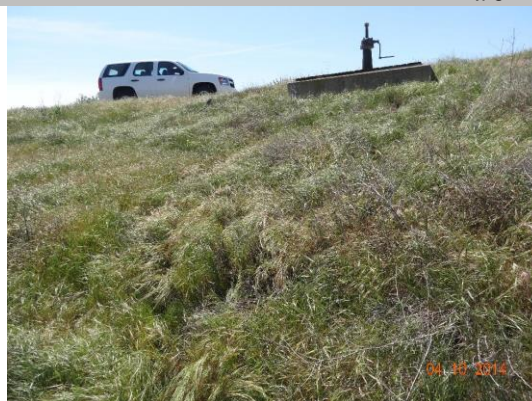
Photo 2 of 3 : UCIP_FA_2019_39481_66632.jpg

View of waterward slope covered by dense vegetation.

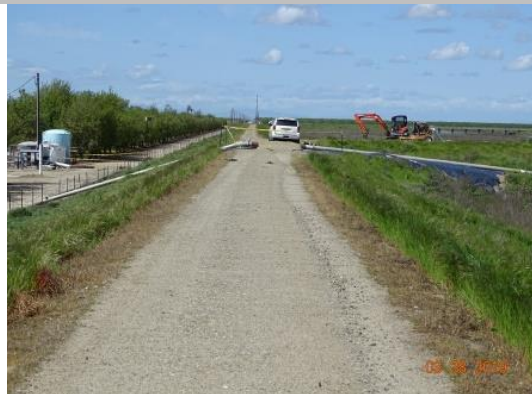
Photo 2 of 2 : FA_2019_NA0010_124_130_20190912_00051.jpg

LM Start	35.84	Rating **	A/W	Issue No.	130 (cont)	
LM End	35.84	Issue Type +	En	Location *	CR	
Category	Earthen Levee			GPS Latitude/Longitude		
				Start		End
Item	Encroachments			36.974417 °		36.974417 °
				-120.374479 °		-120.374479 °
DWR ID	DWR_NA0010_06_s_2019_130					
Comment Code						
PI : Pipe						
Inspector Comment						
Temporary pipe has been removed. Should monitor to ensure it is not reinstalled.

View of pipe crossing looking downstream. (Spring 2019)

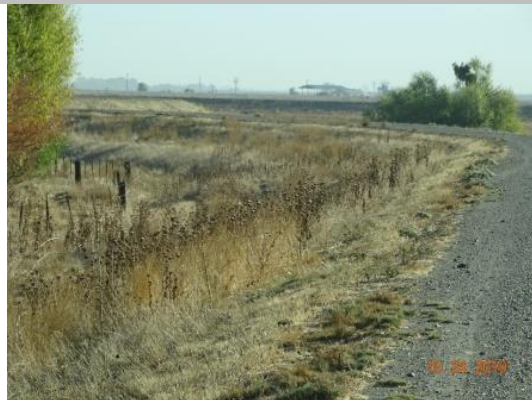
Photo 1 of 1 : FA_2019_NA0010_125_17_20191112_00047.jpg

LM Start	0.00	Rating **	U	Issue No.	17
LM End	0.53	Issue Type +	Ma	Location *	LS
Category	Earthen Levee			GPS Latitude/Longitude	
				Start	End
Item	Vegetation			37.255593°	37.259195°
				-120.772325°	-120.764838°
DWR ID	DWR_NA0010_07_f_2019_17				
Comment Code					
V1 : Control annual grass and weeds on the levee slopes and easements.					
Inspector Comment

View of the landside slope looking upstream. (Fall 2019)

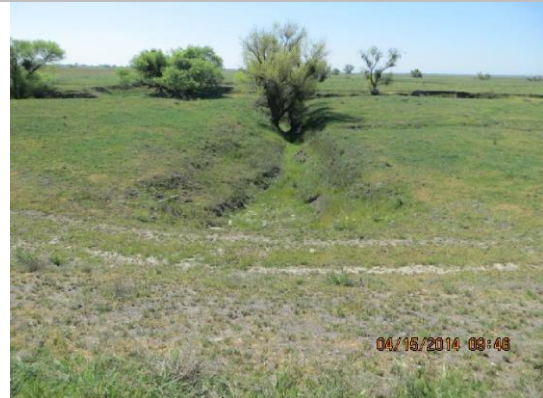
Photo 1 of 3 : UCIP_FA_2019_49966_60954.jpg

Comment Code						
Inspector Comment						
DS_ID:19892						
FS_ID:49966						
EP_NO: N/A						
Repair Type: Non-Urgent						
Crossing Status: Found						
UCIP Comments: 07/20/2016 Inlet blocked off by wooden board. Dense vegetation limits the inspector's visibility to identify signs of pipe failure (leaks) along WS and LS. Crossing downgraded from Urgent to Non-Urgent. (DWR UCIP - omagana)04/15/2014 Flapgate partially blocked by soil buildup at WS toe. (DWR UCIP - W. Wylie)						
FIELD_STRUCT_DESC: 24-inch corrugated metal gravity drainage pipe through the levee, 10.8 feet below the crown. Flap gate on the waterside (WS) end. Concrete headwall on the landside (LS) end. Concrete U-shaped headwall on the WS end. [Additional Reference(s): DWR Levee Log, 2002. USACE San Joaquin O&M Manual 601.1, 1967, (HLM 0.07)].						
FS Date: 7/20/2016

Pipe and headwall at WS toe.

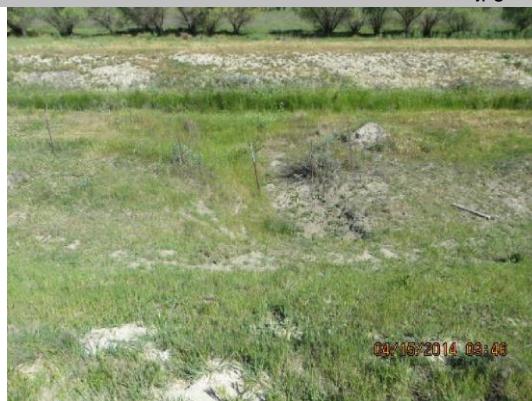
Photo 3 of 3 : UCIP_FA_2019_49966_60953.jpg

Comment Code						
Inspector Comment						
DS_ID:19892						
FS_ID:49966						
EP_NO: N/A						
Repair Type: Non-Urgent						
Crossing Status: Found						
UCIP Comments: 07/20/2016 Inlet blocked off by wooden board. Dense vegetation limits the inspector's visibility to identify signs of pipe failure (leaks) along WS and LS. Crossing downgraded from Urgent to Non-Urgent. (DWR UCIP - omagana)04/15/2014 Flapgate partially blocked by soil buildup at WS toe. (DWR UCIP - W. Wylie)						
FIELD_STRUCT_DESC: 24-inch corrugated metal gravity drainage pipe through the levee, 10.8 feet below the crown. Flap gate on the waterside (WS) end. Concrete headwall on the landside (LS) end. Concrete U-shaped headwall on the WS end. [Additional Reference(s): DWR Levee Log, 2002. USACE San Joaquin O&M Manual 601.1, 1967, (HLM 0.07)].						
FS Date: 7/20/2016

Pipe and headwall at LS toe.

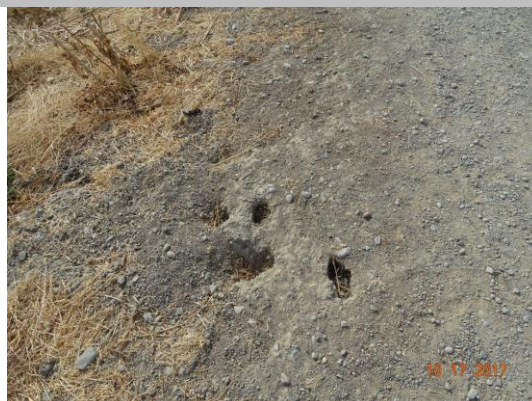
Photo 1 of 2 : FA_2019_NA0010_125_29_20190912_00012.jpg

LM Start	0.24	Rating **	M	Issue No.	29
LM End	0.50	Issue Type +	Ma	Location *	LS
Category	Earthen Levee			GPS Latitude/Longitude	
				Start	End
Item	Animal Control			37.256936°	37.258722°
				-120.768472°	-120.764867°
DWR ID	DWR_NA0010_07_s_2012_29				
Comment Code					
A3 : No rodents visible, but rodent burrows visible; need to backfill and compact or grout burrows.					
Inspector Comment					
Several rodent holes were noted on the landside and waterside slope and shoulder.

Looking north at landside slope.

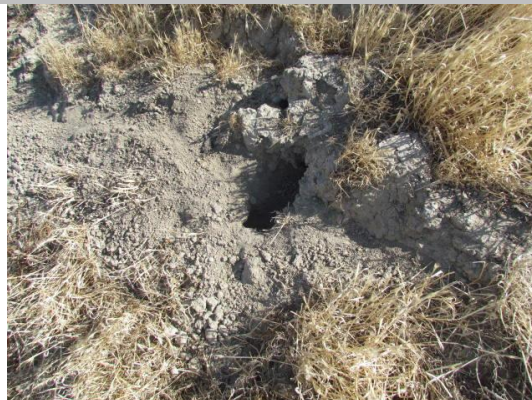
Photo 2 of 2 : FA_2019_NA0010_125_29_20190912_00013.jpg

LM Start	0.24	Rating **	M	Issue No.	29 (cont)	
LM End	0.50	Issue Type +	Ma	Location *	LS	
Category	Earthen Levee			GPS Latitude/Longitude		
				Start		End
Item	Animal Control			37.256936°	37.258722°	
				-120.768472°	-120.764867°	
DWR ID	DWR_NA0010_07_s_2012_29					
Comment Code						
A3 : No rodents visible, but rodent burrows visible; need to backfill and compact or grout burrows.						
Inspector Comment						
Several rodent holes were noted on the landside and waterside slope and shoulder.

Looking at typical view of rodent holes on landward slope.

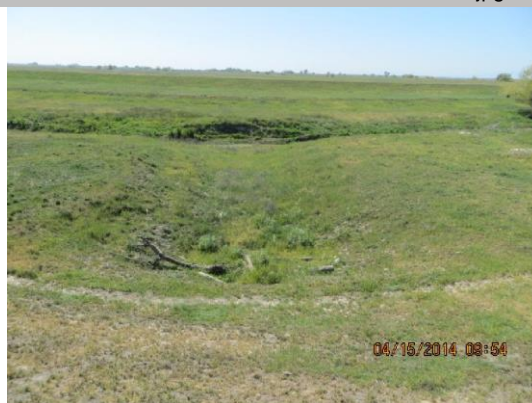
Photo 1 of 3 : UCIP_FA_2019_33712_60958.jpg

LM Start	0.33	Rating **	A/W	Issue No.	31
LM End	0.33	Issue Type +	Ma	Location *	
Category	Supplemental			GPS Latitude/Longitude	
				Start	End
Item	DRAFT DWR UCIP LMA Responsibility			37.257691 °	37.257691 °
				-120.767203 °	-120.767203 °
DWR ID	19893				
Comment Code					
Inspector Comment					
DS_ID:19893					
FS_ID:33712					
EP_NO: N/A					
Repair Type: No Action Needed					
Crossing Status: Found					
UCIP Comments:					
FIELD_STRUCT_DESC: 24-inch corrugated metal gravity drainage pipe through the levee, 11.1 feet below the crown. Flap gate on the waterside (WS) end. Concrete headwall on the landside (LS) end. Concrete U-shaped headwall on the WS end. [Additional Reference(s): DWR Levee Log, 2002. USACE San Joaquin O&M Manual 601.1, 1967, (HLM 0.33)].					
FS Date: 4/15/2014

Pipe and headwall on WS toe.

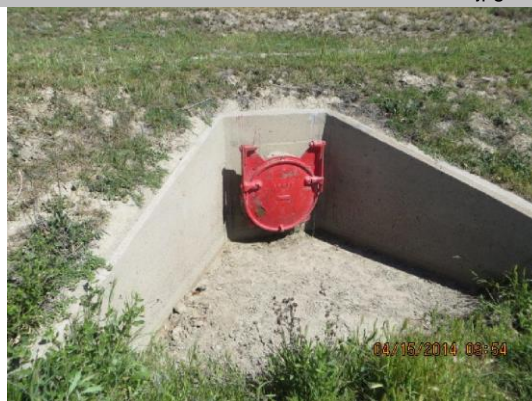
Photo 2 of 3 : UCIP_FA_2019_33712_60957.jpg

LM Start	0.33	Rating **	A/W	Issue No.	31 (cont)	
LM End	0.33	Issue Type +	Ma	Location *		
Category	Supplemental			GPS Latitude/Longitude		
				Start		End
Item	DRAFT DWR UCIP LMA Responsibility			37.257691 °		37.257691 °
				-120.767203 °		-120.767203 °
DWR ID	19893					
Comment Code						
Inspector Comment						
DS_ID:19893 FS_ID:33712 EP_NO: N/A Repair Type: No Action Needed Crossing Status: Found UCIP Comments: FIELD_STRUCT_DESC: 24-inch corrugated metal gravity drainage pipe through the levee, 11.1 feet below the crown. Flap gate on the waterside (WS) end. Concrete headwall on the landside (LS) end. Concrete U-shaped headwall on the WS end. [Additional Reference(s): DWR Levee Log, 2002. USACE San Joaquin O&M Manual 601.1, 1967, (HLM 0.33)]. FS Date: 4/15/2014

Pipe, headwall, and flapgate on WS toe.

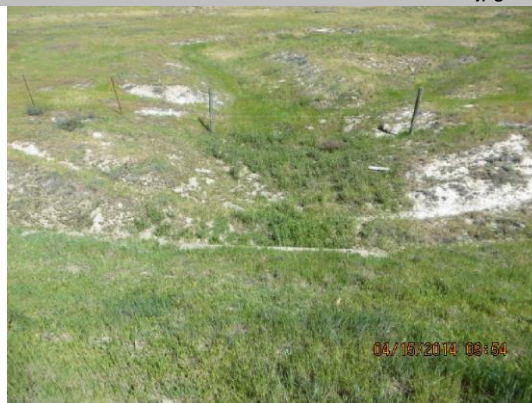
Photo 3 of 3 : UCIP_FA_2019_33712_60959.jpg

Pipe and headwall on LS toe.

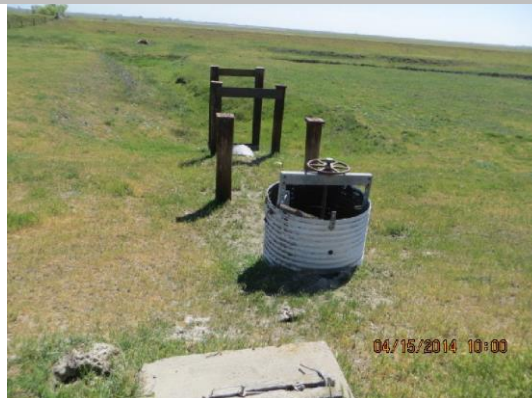
Photo 1 of 3 : UCIP_FA_2019_33713_60963.jpg

Comment Code						
Inspector Comment						
DS_ID:19894						
FS_ID:33713						
EP_NO: N/A						
Repair Type: Non-Urgent						
Crossing Status: Found						
UCIP Comments: 04/15/2014 Slide gate not operable, but left in closed position. Need to reinstall covers over slide gate standpipe. (DWR UCIP - W. Wylie)						
FIELD_STRUCT_DESC: 36-inch corrugated metal gravity drainage pipe through the levee, 9.7 feet below the crown. Slide gate in a 48-inch corrugated metal pipe (CMP) riser on the landside (LS) slope. Concrete U-shaped headwall on the LS end. Inlet channel cobble revetted. Dilapidated wooden pier on the waterside (WS). WS slope and outlet ditch cobble revetted. [Additional Reference(s): DWR Levee Log, 2002. USACE San Joaquin O&M Manual 601.1, 1967, (HLM 0.49)].						
FS Date: 4/15/2014

Slide gate in CMP riser on WS slope.

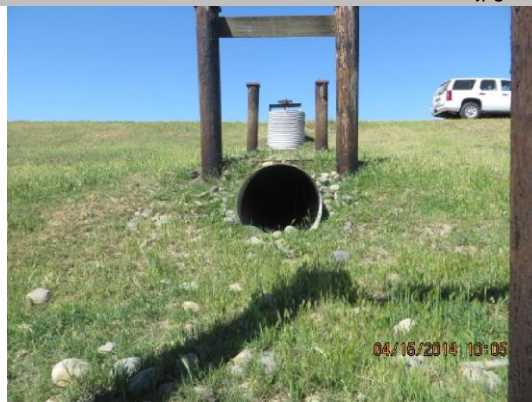
Photo 2 of 3 : UCIP_FA_2019_33713_60965.jpg

Outlet on WS slope.

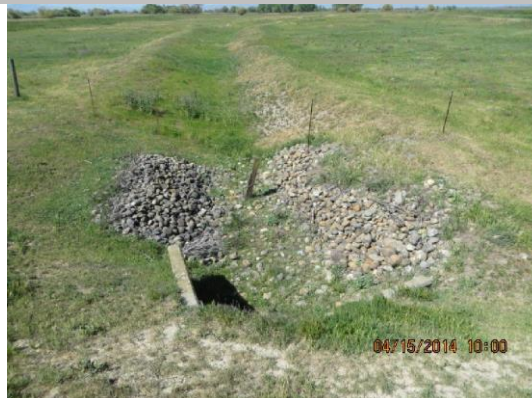
Photo 3 of 3 : UCIP_FA_2019_33713_60964.jpg

Comment Code						
Inspector Comment						
DS_ID:19894 FS_ID:33713 EP_NO: N/A Repair Type: Non-Urgent Crossing Status: Found UCIP Comments: 04/15/2014 Slide gate not operable, but left in closed position. Need to reinstall covers over slide gate standpipe. (DWR UCIP - W. Wylie) FIELD_STRUCT_DESC: 36-inch corrugated metal gravity drainage pipe through the levee, 9.7 feet below the crown. Slide gate in a 48-inch corrugated metal pipe (CMP) riser on the landside (LS) slope. Concrete U-shaped headwall on the LS end. Inlet channel cobble revetted. Dilapidated wooden pier on the waterside (WS). WS slope and outlet ditch cobble revetted. [Additional Reference(s): DWR Levee Log, 2002. USACE San Joaquin O&M Manual 601.1, 1967, (HLM 0.49)]. FS Date: 4/15/2014

Pipe and headwall on LS toe.

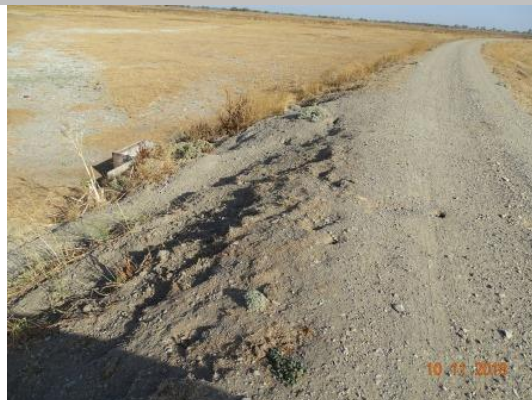
Photo 1 of 2 : FA_2019_NA0010_125_18_20190912_00008.jpg

LM Start	0.53	Rating **	M	Issue No.	18
LM End	0.53	Issue Type +	Ma	Location *	LS
Category	Earthen Levee			GPS Latitude/Longitude	
				Start	End
Item	Slope Stability			37.259097°	37.259097°
				-120.764846°	-120.764846°
DWR ID	DWR_NA0010_07_f_2018_18				
Comment Code					
S2 : Repair the levee slope damaged by foot traffic and prevent access where possible.					
Inspector Comment					
There is livestock damage to the landside slope.

View of damage from livestock looking upstream. (Fall 2018)

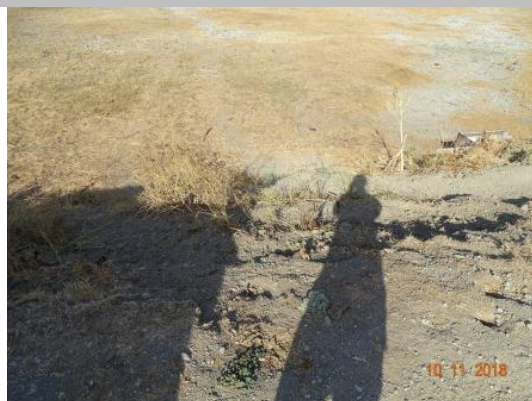
Photo 2 of 2 : FA_2019_NA0010_125_18_20190912_00009.jpg

LM Start	0.53	Rating **	M	Issue No.	18 (cont)	
LM End	0.53	Issue Type +	Ma	Location *	LS	
Category	Earthen Levee			GPS Latitude/Longitude		
				Start		End
Item	Slope Stability			37.259097 °		37.259097 °
				-120.764846 °		-120.764846 °
DWR ID	DWR_NA0010_07_f_2018_18					
Comment Code						
S2 : Repair the levee slope damaged by foot traffic and prevent access where possible.						
Inspector Comment						
There is livestock damage to the landside slope.

View of damage looking down landside slope. (2018)

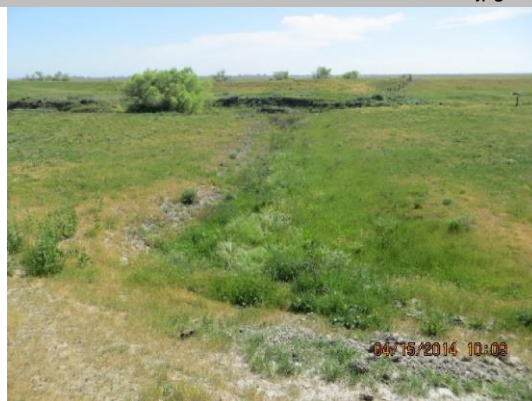
Photo 1 of 3 : UCIP_FA_2019_33723_60981.jpg

LM Start	0.53	Rating **	A/W	Issue No.	33
LM End	0.53	Issue Type +	Ma	Location *	
Category	Supplemental			GPS Latitude/Longitude	
				Start	End
Item	DRAFT DWR UCIP LMA Responsibility			37.259163 °	37.259163 °
				-120.764860 °	-120.764860 °
DWR ID	19895				
Comment Code					
Inspector Comment					
DS_ID:19895					
FS_ID:33723					
EP_NO: N/A					
Repair Type: No Action Needed					
Crossing Status: Found					
UCIP Comments:					
FIELD_STRUCT_DESC: 24-inch corrugated metal gravity drainage pipe through the levee, 9 feet below the crown. Flap gate on the waterside (WS) end. Concrete headwall with a wooden weir at the inlet on the landside (LS) toe. Concrete U-shaped headwall on the WS toe.					
[Additional Reference(s): DWR Levee Log, 2002. USACE San Joaquin O&M Manual 601.1, 1967, (HLM 0.53)].					
FS Date: 4/15/2014

Headwall and flapgate on WS toe.

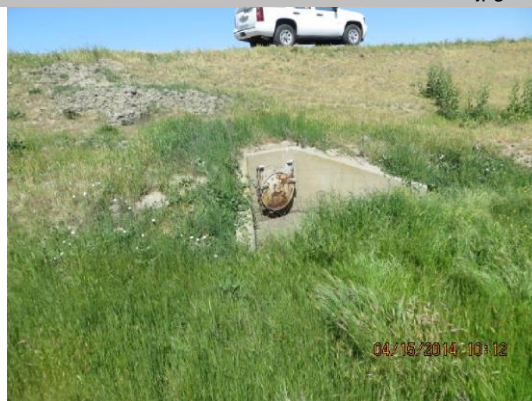
Photo 2 of 3 : UCIP_FA_2019_33723_60983.jpg

LM Start	0.53	Rating **	A/W	Issue No.	33 (cont)	
LM End	0.53	Issue Type +	Ma	Location *		
Category	Supplemental			GPS Latitude/Longitude		
				Start		End
Item	DRAFT DWR UCIP LMA Responsibility			37.259163 °		37.259163 °
				-120.764860 °		-120.764860 °
DWR ID	19895					
Comment Code						
Inspector Comment						
DS_ID:19895 FS_ID:33723 EP_NO: N/A Repair Type: No Action Needed Crossing Status: Found UCIP Comments: FIELD_STRUCT_DESC: 24-inch corrugated metal gravity drainage pipe through the levee, 9 feet below the crown. Flap gate on the waterside (WS) end. Concrete headwall with a wooden weir at the inlet on the landside (LS) toe. Concrete U-shaped headwall on the WS toe. [Additional Reference(s): DWR Levee Log, 2002. USACE San Joaquin O&M Manual 601.1, 1967, (HLM 0.53)]. FS Date: 4/15/2014

Flapgate on concrete headwall at WS toe.

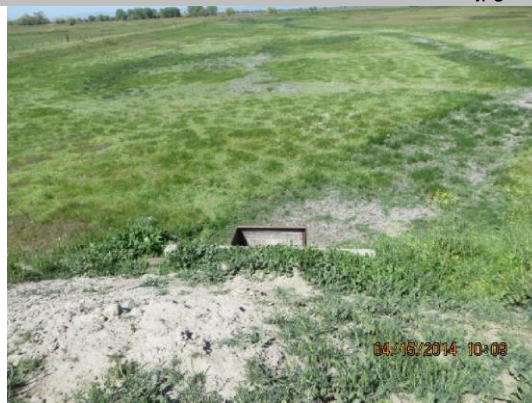
Photo 3 of 3 : UCIP_FA_2019_33723_60982.jpg

Headwall, pipe, and wier on LS toe.

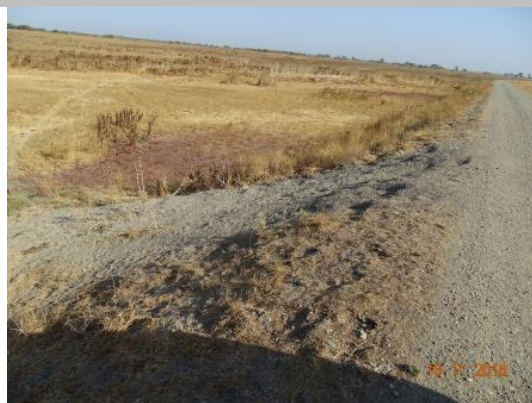
Photo 1 of 1 : FA_2019_NA0010_125_19_20190912_00010.jpg

LM Start	0.70	Rating **	M	Issue No.	19
LM End	0.70	Issue Type +	Ma	Location *	LS
Category	Earthen Levee			GPS Latitude/Longitude	
				Start	End
Item	Slope Stability			37.261337°	37.261337°
				-120.763303°	-120.763303°
DWR ID	DWR_NA0010_07_f_2018_19				
Comment Code					
S2 : Repair the levee slope damaged by foot traffic and prevent access where possible.					
Inspector Comment					
There is livestock damage to the landside slope.

Damage to landside slope from livestock. (Fall 2018)

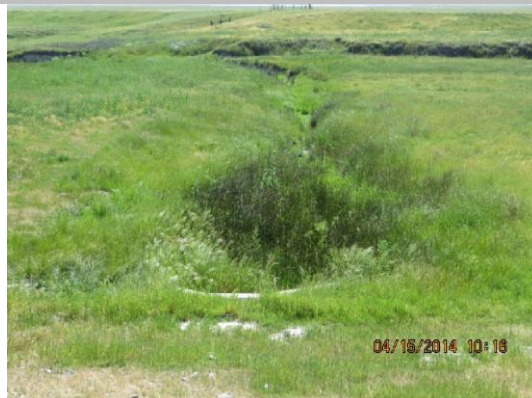
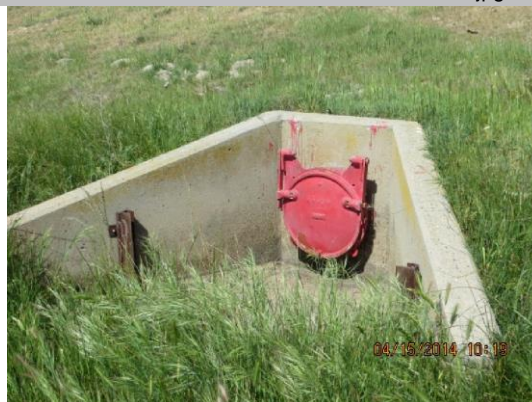
Comment Code					
Inspector Comment					
DS_ID:19896 FS_ID:39507 EP_NO: N/A Repair Type: Non-Urgent Crossing Status: Found UCIP Comments: 04/15/2014 Need to contact owner. Heavy sediment buildup at inlet due to animal activity should be cleared. (DWR UCIP - W. Wylie) FIELD_STRUCT_DESC: 24-inch corrugated metal gravity drainage pipe through the levee, 9.8 feet below the crown. Flap gate on the waterside (WS) end. Wooden weir on concrete headwall at the landside (LS) toe. 36-inch concrete riser at the LS toe. Concrete U-shaped headwall on the WS end. Concrete standpipe on the LS. [Additional Reference(s): DWR Levee Log, 2002. USACE San Joaquin O&M Manual 601.1, 1967, (HLM 0.85)]. FS Date: 4/15/2014

Headwall and flapgate on WS toe.

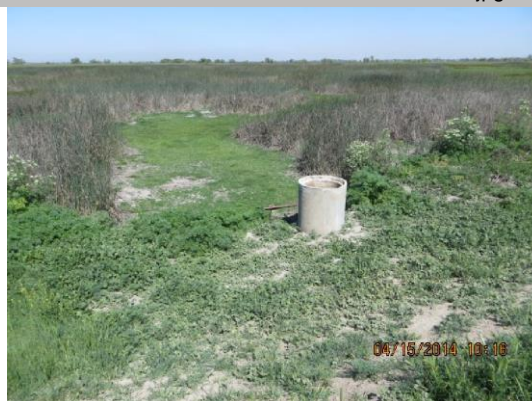
Photo 3 of 3 : UCIP_FA_2019_39507_60987.jpg

Comment Code						
Inspector Comment						
DS_ID:19896						
FS_ID:39507						
EP_NO: N/A						
Repair Type: Non-Urgent						
Crossing Status: Found						
UCIP Comments: 04/15/2014 Need to contact owner. Heavy sediment buildup at inlet due to animal activity should be cleared. (DWR UCIP - W. Wylie)						
FIELD_STRUCT_DESC: 24-inch corrugated metal gravity drainage pipe through the levee, 9.8 feet below the crown. Flap gate on the waterside (WS) end. Wooden weir on concrete headwall at the landside (LS) toe. 36-inch concrete riser at the LS toe. Concrete U-shaped headwall on the WS end. Concrete standpipe on the LS. [Additional Reference(s): DWR Levee Log, 2002. USACE San Joaquin O&M Manual 601.1, 1967, (HLM 0.85)].						
FS Date: 4/15/2014

Concrete riser, concrete headwall, weir, and pipe at LS toe.

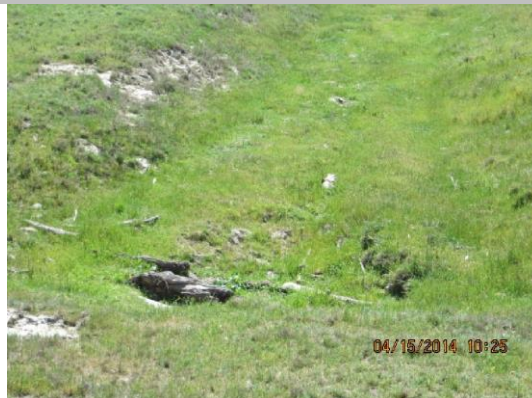
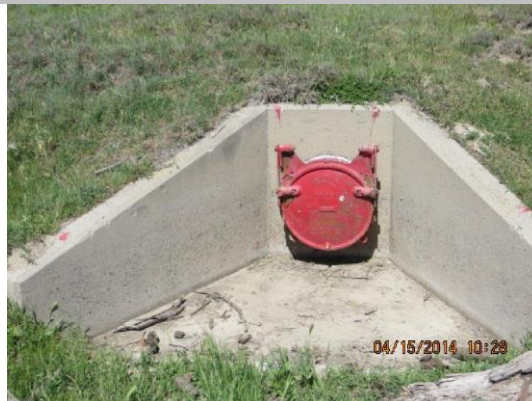
Concrete headwall and flapgate at WS toe.

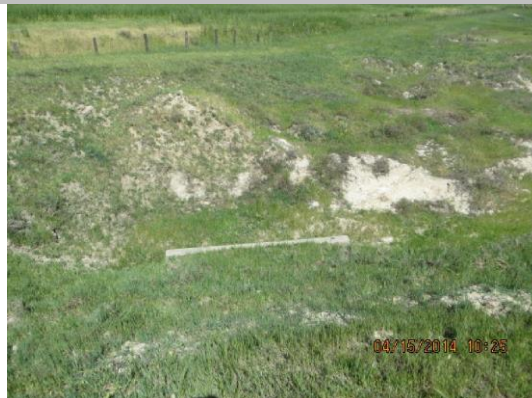
Photo 3 of 3 : UCIP_FA_2019_33725_60992.jpg

Concrete headwall and pipe on LS toe.

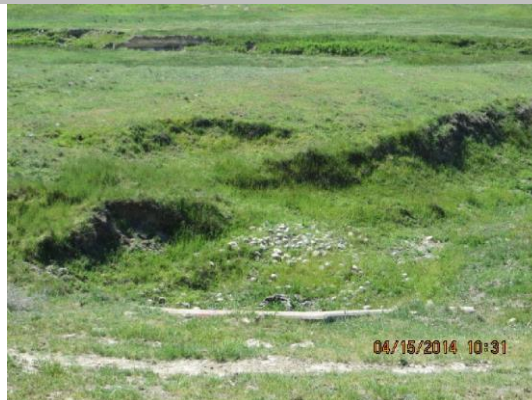
Photo 1 of 3 : UCIP_FA_2019_33726_60996.jpg

Pipe, flapgate, and headwall on WS toe.

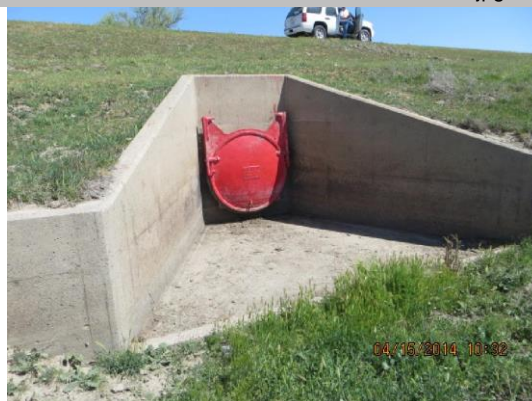
Photo 2 of 3 : UCIP_FA_2019_33726_60995.jpg

Flapgate at headwall on WS toe.

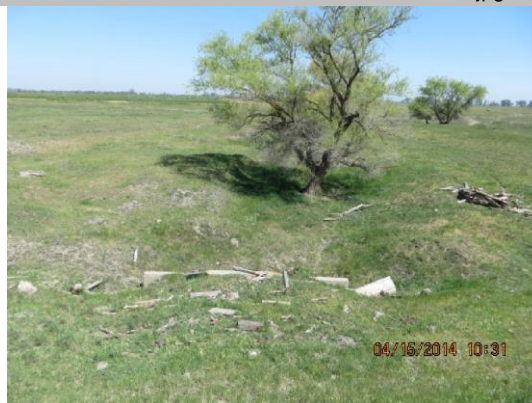
Photo 3 of 3 : UCIP_FA_2019_33726_60997.jpg

Pipe and headwall on LS toe.

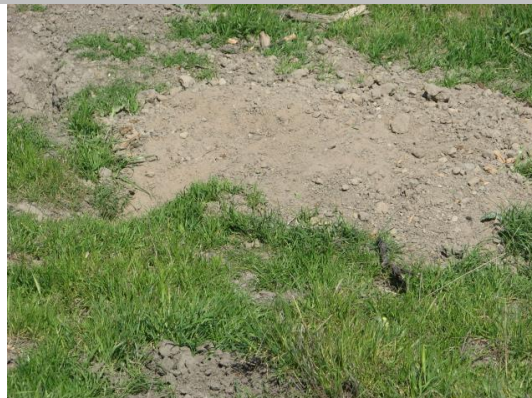
Photo 1 of 2 : FA_2019_NA0010_125_6_20190912_00003.jpg

LM Start	1.50	Rating **	M	Issue No.	6
LM End	1.51	Issue Type +	Ma	Location *	LS
Category	Earthen Levee			GPS Latitude/Longitude	
				Start	End
Item	Animal Control			37.263955 °	37.263885 °
				-120.750751 °	-120.750527 °
DWR ID	DWR_NA0010_07_s_2014_6				
Comment Code					
A1 : Exterminate rodents and backfill and compact or grout burrows.					
Inspector Comment

Looking at typical view of rodent holes within this section. (Spring 2018)

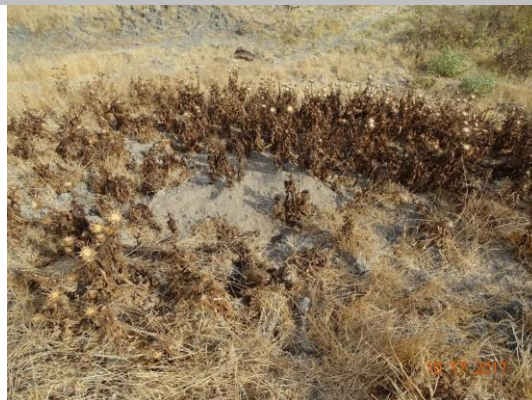
Photo 2 of 2 : FA_2019_NA0010_125_6_20190912_00004.jpg

Looking northwest at landside slope.

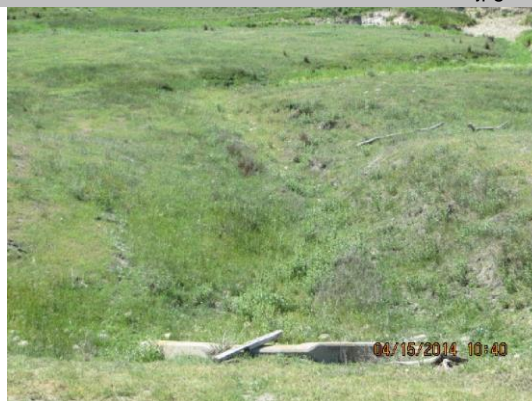
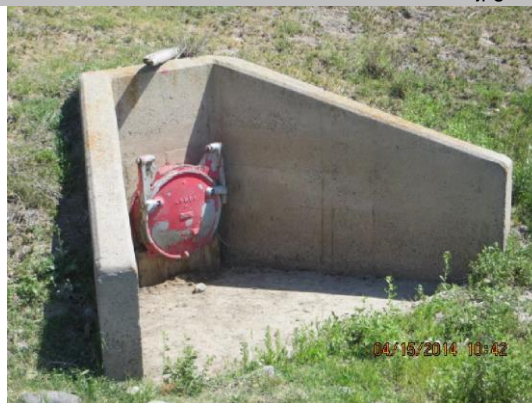
Pipe, headwall and flapgate on WS toe.

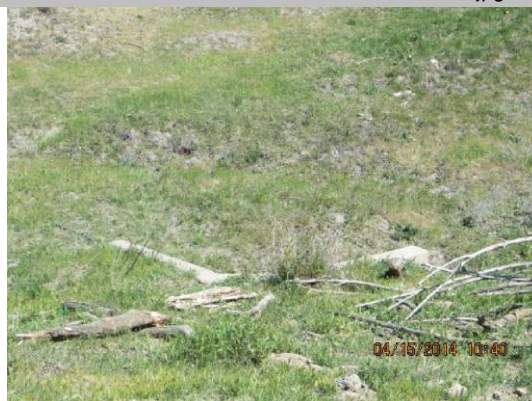
Photo 3 of 3 : UCIP_FA_2019_33727_61002.jpg

Headwall and pipe on LS toe.

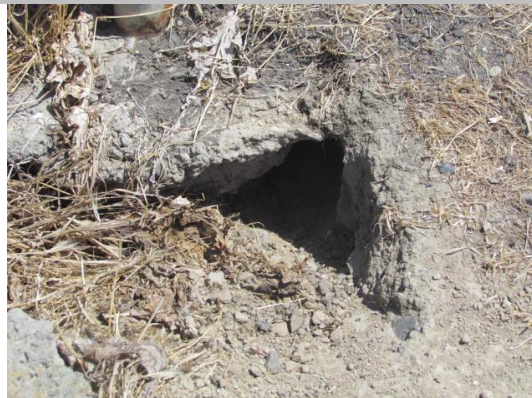
Photo 2 of 2 : FA_2019_NA0010_125_12_20190912_00006.jpg

LM Start	2.09	Rating **	M	Issue No.	12 (cont)	
LM End	2.09	Issue Type +	Ma	Location *	LS	
Category	Earthen Levee			GPS Latitude/Longitude		
				Start		End
Item	Animal Control			37.259187 °		37.259187 °
				-120.742551 °		-120.742551 °
DWR ID	DWR_NA0010_07_f_2018_12					
Comment Code						
A3 : No rodents visible, but rodent burrows visible; need to backfill and compact or grout burrows.						
Inspector Comment						
Rodent activity is noted next to the fence post.

Looking at rodent activity next to fence post

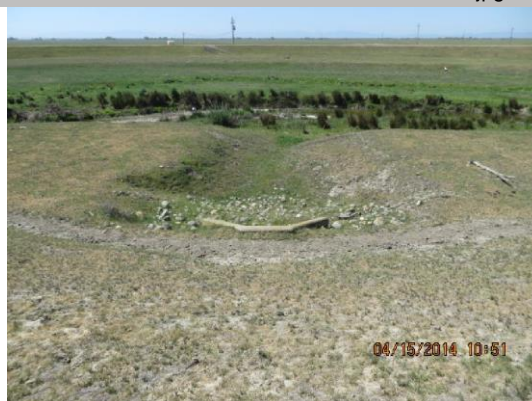
Photo 1 of 3 : UCIP_FA_2019_33728_61006.jpg

Headwall and flapgate on WS toe.

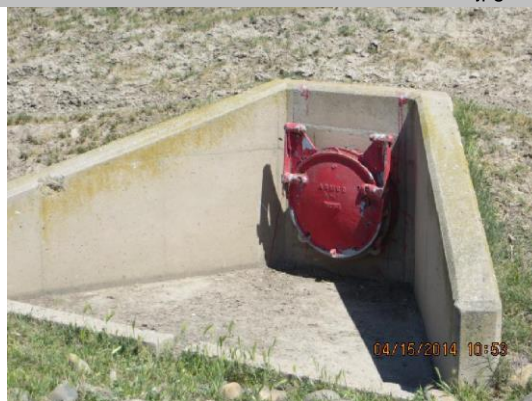
Photo 2 of 3 : UCIP_FA_2019_33728_61008.jpg

Concrete headwall and flapgate at WS toe.

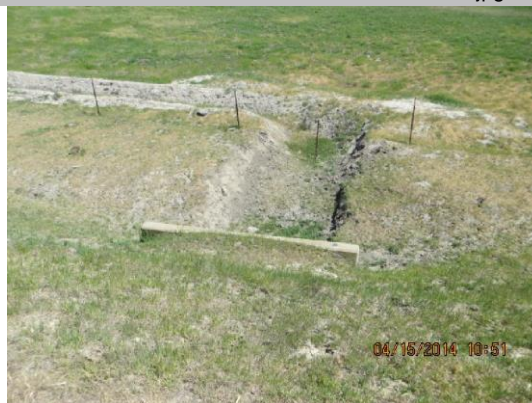
Photo 3 of 3 : UCIP_FA_2019_33728_61007.jpg

Concrete headwall and pipe on LS toe.

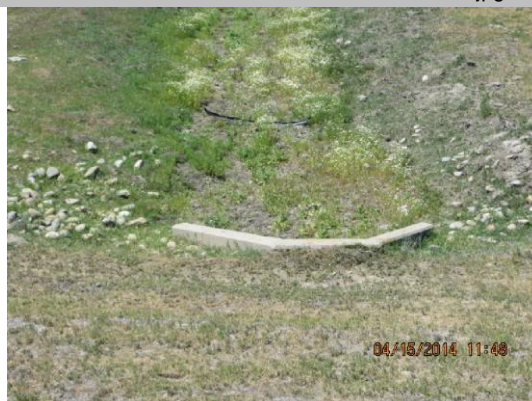
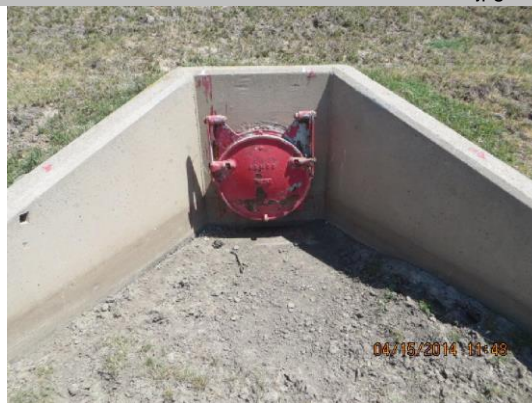
Concrete headwall and flapgate on WS toe.

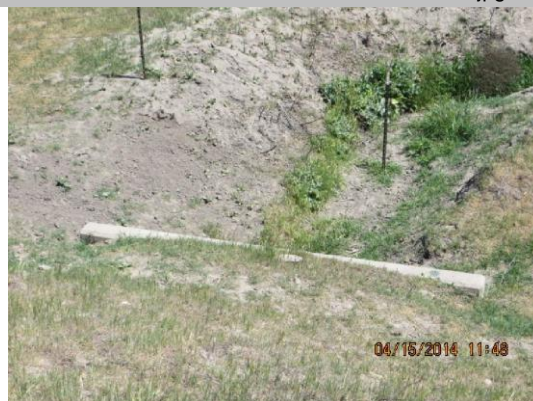
Photo 3 of 3 : UCIP_FA_2019_33729_61012.jpg

Concrete headwall and pipe at LS toe.

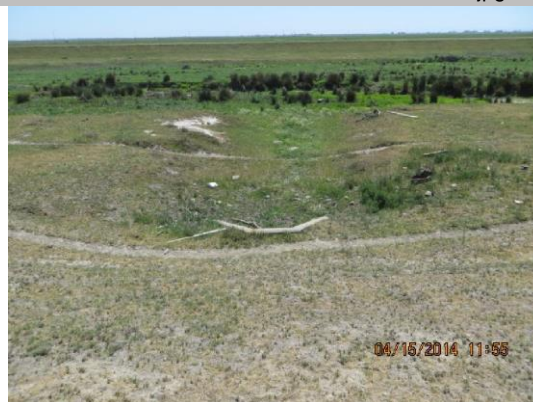
Photo 1 of 3 : UCIP_FA_2019_39508_61016.jpg

Comment Code						
Inspector Comment						
DS_ID:19901						
FS_ID:39508						
EP_NO: N/A						
Repair Type: Non-Urgent						
Crossing Status: Found						
UCIP Comments: 04/15/2014 Some sediment buildup at landward toe and inside pipe--recommend clearing. (DWR UCIP - W. Wylie)						
FIELD_STRUCT_DESC: 24-inch corrugated metal gravity drainage pipe through the levee, 10.4 feet below the crown. Flap gate on the waterside (WS) end. Concrete headwall on the landside (LS) end.						
Concrete U-shaped headwall on the WS end. [Additional Reference(s): DWR Levee Log, 2002. USACE San Joaquin O&M Manual 601.1, 1967, (HLM 3.09)].						
FS Date: 4/15/2014

Headwall, pipe, and flapgate on WS toe.

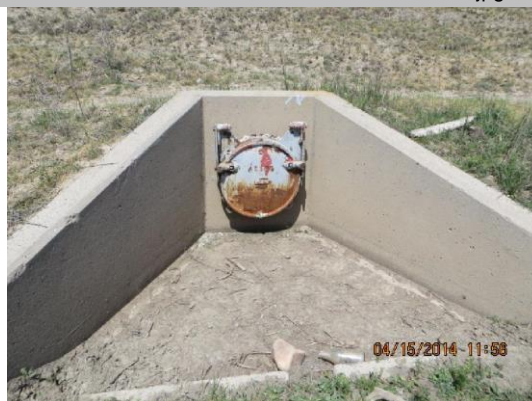
Photo 2 of 3 : UCIP_FA_2019_39508_61015.jpg

Headwall, pipe, and flapgate on WS toe.

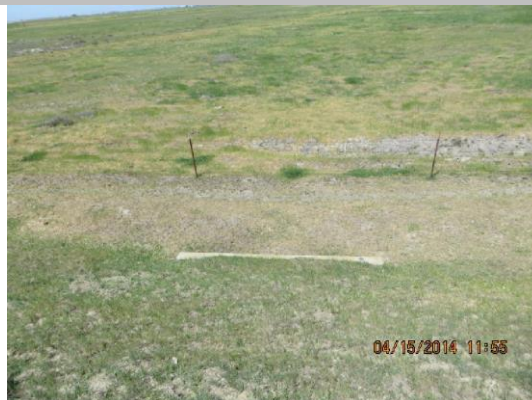
Photo 3 of 3 : UCIP_FA_2019_39508_61017.jpg

Headwall and pipe on LS toe.

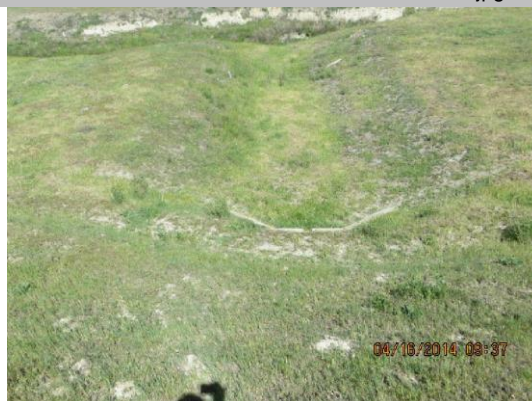
Photo 1 of 3 : UCIP_FA_2019_33751_61068.jpg

Headwall and flapgate on WS toe.

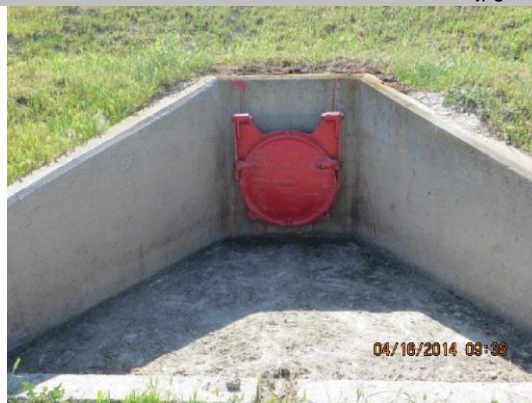
Photo 2 of 3 : UCIP_FA_2019_33751_61067.jpg

Headwall and flapgate on WS toe.

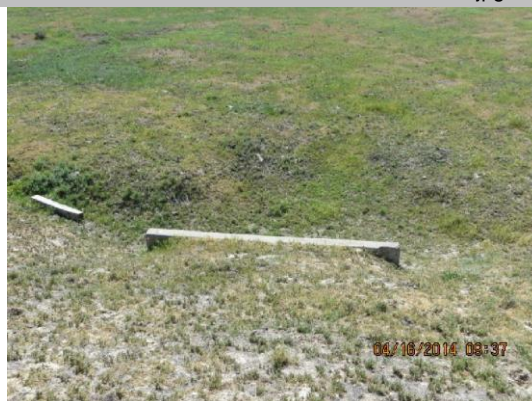
Photo 3 of 3 : UCIP_FA_2019_33751_61069.jpg

LM Start	0.23	Rating **	A/W	Issue No.	30 (cont)	
LM End	0.23	Issue Type +	Ma	Location *		
Category	Supplemental			GPS Latitude/Longitude		
				Start	End	
Item	DRAFT DWR UCIP LMA Responsibility			37.256092 °	37.256092 °	
				-120.767873 °	-120.767873 °	
DWR ID	19903					
Comment Code						
Inspector Comment						
DS_ID:19903 FS_ID:33751 EP_NO: N/A Repair Type: No Action Needed Crossing Status: Found UCIP Comments: FIELD_STRUCT_DESC: 24-inch corrugated metal gravity drainage pipe through the levee, 9.6 feet below the crown. Flap gate on the waterside (WS) end. Concrete headwall on the landside (LS) end. Concrete U-shaped headwall on the WS end. [Additional Reference(s): DWR Levee Log, 2002. USACE San Joaquin O&M Manual 601.1, 1967, (HLM 0.23)]. FS Date: 4/16/2014

Concrete headwall on LS toe.

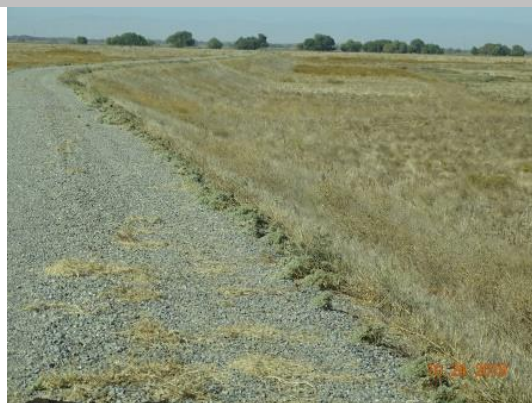
Photo 1 of 1 : FA_2019_NA0010_126_27_20191112_00045.jpg

LM Start	0.52	Rating **	M	Issue No.	27
LM End	1.36	Issue Type +	Ma	Location *	WS
Category	Earthen Levee			GPS Latitude/Longitude	
				Start	End
Item	Vegetation			37.257915 °	37.263177 °
				-120.763628 °	-120.752713 °
DWR ID	DWR_NA0010_08_f_2019_27				
Comment Code					
V1 : Control annual grass and weeds on the levee slopes and easements.					
Inspector Comment

View of the waterside slope looking downstream. (Fall 2019)

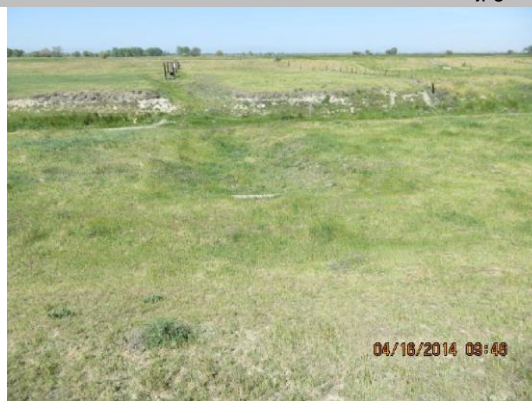
Photo 1 of 3 : UCIP_FA_2019_33752_61073.jpg

LM Start	0.57	Rating **	A/W	Issue No.	31
LM End	0.57	Issue Type +	Ma	Location *	
Category	Supplemental			GPS Latitude/Longitude	
				Start	End
Item	DRAFT DWR UCIP LMA Responsibility			37.258604 °	37.258604 °
				-120.763588 °	-120.763588 °
DWR ID	19904				
Comment Code					
Inspector Comment					
DS_ID:19904					
FS_ID:33752					
EP_NO: N/A					
Repair Type: No Action Needed					
Crossing Status: Found					
UCIP Comments:					
FIELD_STRUCT_DESC: 24-inch corrugated metal gravity drainage pipe					
through the levee, 12.4 feet below the crown. Flap gate on the					
waterside (WS) end. Concrete headwall on each end. [Additional					
Reference(s): DWR Levee Log, 2002. USACE San Joaquin O&M					
Manual 601.1, 1967, (HLM 0.57)].					
FS Date: 4/16/2014

Pipe, flapgate and headwall on WS toe.

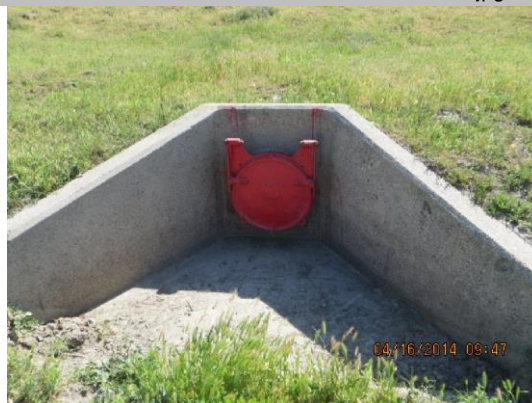
Photo 2 of 3 : UCIP_FA_2019_33752_61072.jpg

Pipe, flapgate and headwall on WS toe.

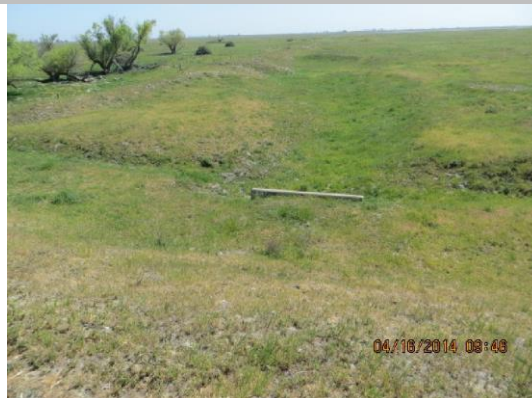
Photo 3 of 3 : UCIP_FA_2019_33752_61074.jpg

LM Start	0.57	Rating **	A/W	Issue No.	31 (cont)	
LM End	0.57	Issue Type +	Ma	Location *		
Category	Supplemental			GPS Latitude/Longitude		
				Start	End	
Item	DRAFT DWR UCIP LMA Responsibility			37.258604 °	37.258604 °	
				-120.763588 °	-120.763588 °	
DWR ID	19904					
Comment Code						
Inspector Comment						
DS_ID:19904						
FS_ID:33752						
EP_NO: N/A						
Repair Type: No Action Needed						
Crossing Status: Found						
UCIP Comments:						
FIELD_STRUCT_DESC: 24-inch corrugated metal gravity drainage pipe through the levee, 12.4 feet below the crown. Flap gate on the waterside (WS) end. Concrete headwall on each end. [Additional Reference(s): DWR Levee Log, 2002. USACE San Joaquin O&M Manual 601.1, 1967, (HLM 0.57)].						
FS Date: 4/16/2014

Pipe and headwall on LS toe.

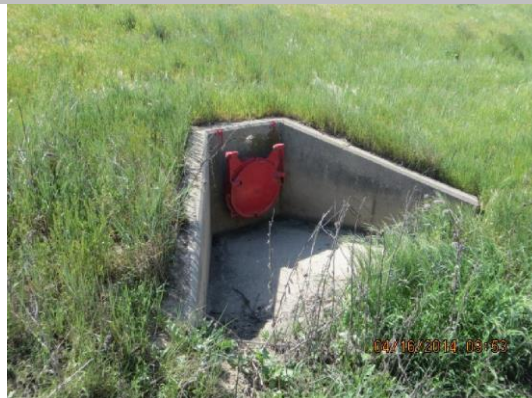
Photo 2 of 3 : UCIP_FA_2019_33753_61080.jpg

LM Start	0.72	Rating **	A/W	Issue No.	32 (cont)	
LM End	0.72	Issue Type +	Ma	Location *		
Category	Supplemental			GPS Latitude/Longitude		
				Start	End	
Item	DRAFT DWR UCIP LMA Responsibility			37.260306 °	37.260306 °	
				-120.762127 °	-120.762127 °	
DWR ID	19905					
Comment Code						
Inspector Comment						
DS_ID:19905 FS_ID:33753 EP_NO: N/A Repair Type: No Action Needed Crossing Status: Found UCIP Comments: FIELD_STRUCT_DESC: 24-inch corrugated metal gravity drainage pipe through the levee, 10 feet below the crown. Flap gate on the waterside (WS) end. Concrete headwall on each end. [Additional Reference(s): DWR Levee Log, 2002. USACE San Joaquin O&M Manual 601.1, 1967, (HLM 0.72)]. FS Date: 4/16/2014

Headwall and flapgate at WS toe.

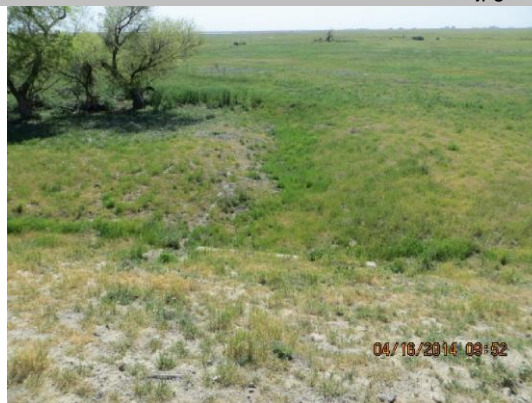
Photo 3 of 3 : UCIP_FA_2019_33753_61079.jpg

Concrete headwall on LS toe.

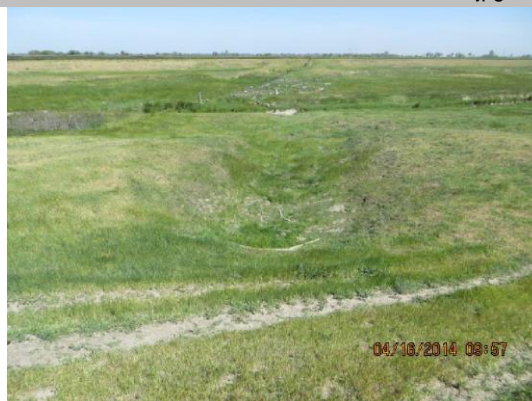
Photo 1 of 3 : UCIP_FA_2019_39887_61084.jpg

LM Start	0.90	Rating **	M	Issue No.	33
LM End	0.90	Issue Type +	Ma	Location *	
Category	Supplemental			GPS Latitude/Longitude	
				Start	End
Item	DRAFT DWR UCIP LMA Responsibility			37.262384 °	37.262384 °
				-120.760528 °	-120.760528 °
DWR ID	19832				
Comment Code					
Inspector Comment					
DS_ID:19832 FS_ID:39887 EP_NO: N/A Repair Type: Non-Urgent Crossing Status: Found UCIP Comments: 04/16/2014 Some sediment buildup at inlet on LS toe. (DWR UCIP - W. Wylie) FIELD_STRUCT_DESC: 24-inch corrugated metal gravity drainage pipe through the levee, 11.5 feet below the crown. Flap gate on the waterside (WS) end. Concrete headwall on each end. [Additional Reference(s): DWR Levee Log, 2002. USACE San Joaquin O&M Manual 601.1, 1967, (HLM 0.89)]. FS Date: 4/16/2014

Headwall, pipe, and flapgate on WS toe.

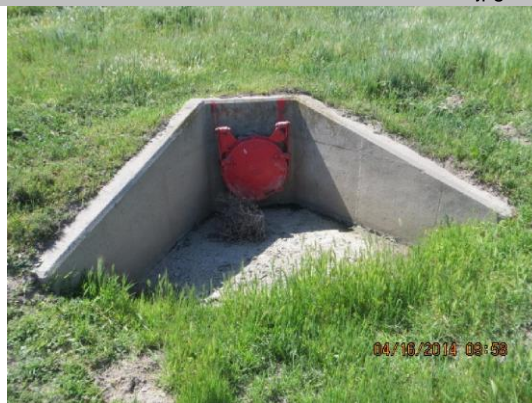
Photo 2 of 3 : UCIP_FA_2019_39887_61083.jpg

Headwall, pipe, and flapgate on WS toe.

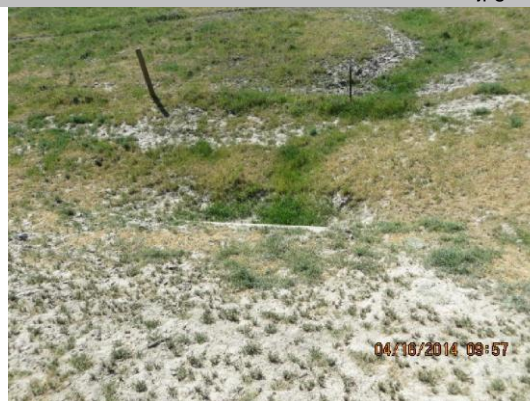
Photo 3 of 3 : UCIP_FA_2019_39887_61085.jpg

LM Start	0.90	Rating **	M	Issue No.	33 (cont)	
LM End	0.90	Issue Type +	Ma	Location *		
Category	Supplemental			GPS Latitude/Longitude		
				Start	End	
Item	DRAFT DWR UCIP LMA Responsibility			37.262384 °	37.262384 °	
				-120.760528 °	-120.760528 °	
DWR ID	19832					
Comment Code						
Inspector Comment						
DS_ID:19832						
FS_ID:39887						
EP_NO: N/A						
Repair Type: Non-Urgent						
Crossing Status: Found						
UCIP Comments: 04/16/2014 Some sediment buildup at inlet on LS toe. (DWR UCIP - W. Wylie)						
FIELD_STRUCT_DESC: 24-inch corrugated metal gravity drainage pipe through the levee, 11.5 feet below the crown. Flap gate on the waterside (WS) end. Concrete headwall on each end. [Additional Reference(s): DWR Levee Log, 2002. USACE San Joaquin O&M Manual 601.1, 1967, (HLM 0.89)].						
FS Date: 4/16/2014

Pipe and headwall on LS toe.

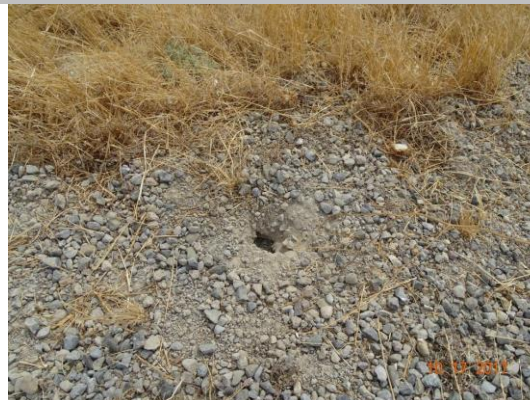
Photo 1 of 1 : FA_2019_NA0010_126_2_20190912_00001.jpg

LM Start	1.20	Rating **	M	Issue No.	2
LM End	1.20	Issue Type +	Ma	Location *	LS
Category	Earthen Levee			GPS Latitude/Longitude	
				Start	End
Item	Animal Control			37.263182 °	37.263183 °
				-120.755650 °	-120.755637 °
DWR ID	DWR_NA0010_08_s_2012_2				
Comment Code					
A3 : No rodents visible, but rodent burrows visible; need to backfill and compact or grout burrows.					
Inspector Comment

Looking south at the landside shoulder.

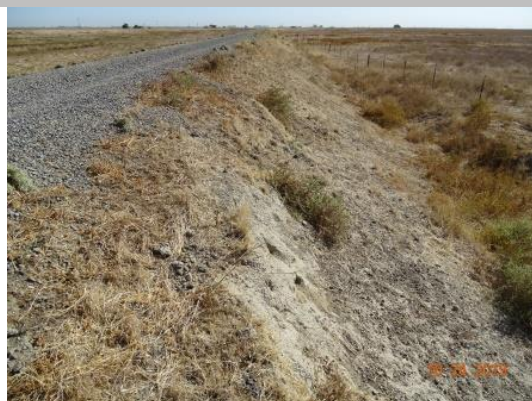
Photo 1 of 1 : FA_2019_NA0010_126_28_20191112_00047.jpg

LM Start	1.21	Rating **	M	Issue No.	28
LM End	1.21	Issue Type +	Ma	Location *	LS
Category	Earthen Levee			GPS Latitude/Longitude	
				Start	End
Item	Slope Stability			37.263179°	37.263179°
				-120.755444°	-120.755444°
DWR ID	DWR_NA0010_08_f_2019_28				
Comment Code					
S2 : Repair the levee slope damaged by foot traffic and prevent access where possible.					
Inspector Comment

View of slope damage on the landside of the levee looking upstream.
(Fall 2019)

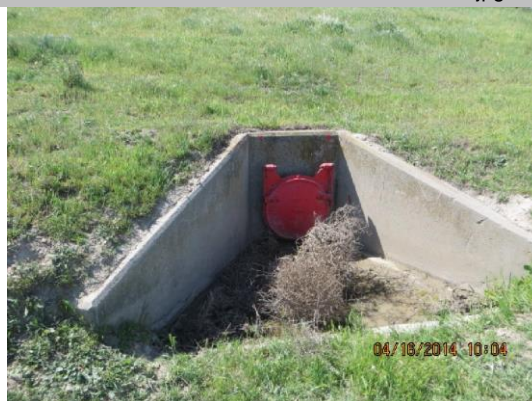
Photo 2 of 3 : UCIP_FA_2019_39509_61091.jpg

LM Start	1.21	Rating **	M	Issue No.	34 (cont)	
LM End	1.21	Issue Type +	Ma	Location *		
Category	Supplemental			GPS Latitude/Longitude		
				Start	End	
Item	DRAFT DWR UCIP LMA Responsibility			37.263188°	37.263188°	
				-120.755399°	-120.755399°	
DWR ID	19833					
Comment Code						
Inspector Comment						
DS_ID:19833 FS_ID:39509 EP_NO: N/A Repair Type: Non-Urgent Crossing Status: Found UCIP Comments: 04/16/2014 Debris blocking landward headwall--recommend clearing. (DWR UCIP - W. Wylie) FIELD_STRUCT_DESC: 24-inch corrugated metal gravity drainage pipe through the levee, 11.6 feet below the crown. Flap gate on the waterside (WS) end. Concrete headwall on each end. [Additional Reference(s): DWR Levee Log, 2002. USACE San Joaquin O&M Manual 601.1, 1967, (HLM 1.21)]. FS Date: 4/16/2014

Concrete headwall, pipe, and flapgate on WS toe.

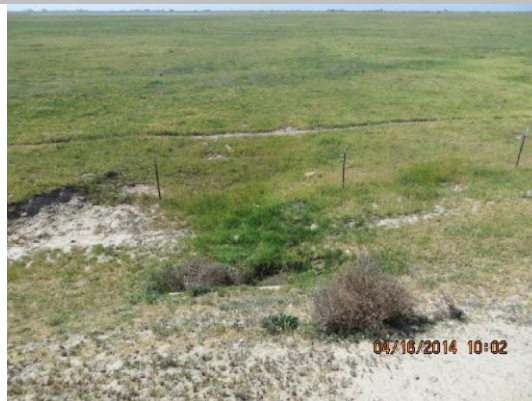
Photo 3 of 3 : UCIP_FA_2019_39509_61089.jpg

Pipe and headwall on LS toe.

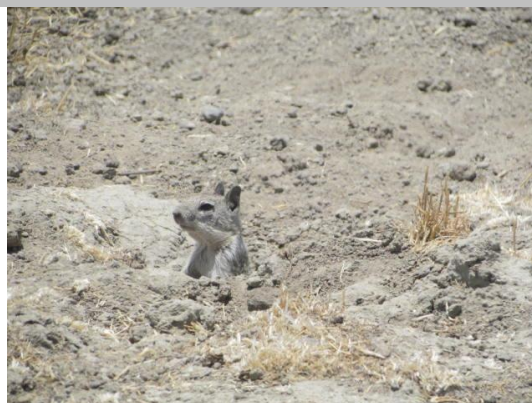
Photo 1 of 1 : FA_2019_NA0010_126_8_20190912_00005.jpg

LM Start	1.38	Rating **	M	Issue No.	8
LM End	1.38	Issue Type +	Ma	Location *	LS
Category	Earthen Levee		GPS Latitude/Longitude		
			Start	End	
Item	Animal Control		37.263175°	37.263175°	
			-120.752307°	-120.752307°	
DWR ID	DWR_NA0010_08_s_2013_8				
Comment Code					
A1 : Exterminate rodents and backfill and compact or grout burrows.					
Inspector Comment

Looking west at rodent holes on landward slope.
