**Flood Control Project Maintenance
Levee Inspections**

Fall 2019 Levee Maintenance Deficiency Summary Report

San Joaquin River Basin

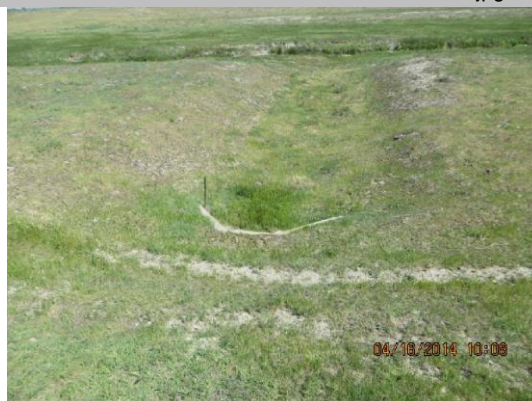
Photo 1 of 3 : UCIP_FA_2019_39510_61094.jpg

LM Start	1.38	Rating **	M	Issue No.	35	
LM End	1.38	Issue Type +	Ma	Location *		
Category	Supplemental			GPS Latitude/Longitude		
				Start	End	
Item	DRAFT DWR UCIP LMA Responsibility			37.263194 °	37.263194 °	
				-120.752299 °	-120.752299 °	
DWR ID	19834					
Comment Code						
Inspector Comment						
DS_ID:19834						
FS_ID:39510						
EP_NO: N/A						
Repair Type: Non-Urgent						
Crossing Status: Found						
UCIP Comments: 04/16/2014 Animal burrows along pipe alignment on LS. Some sediment buildup at LS toe and inside pipe--recommend clearing. (DWR UCIP - W. Wylie)						
FIELD_STRUCT_DESC: 24-inch corrugated metal gravity drainage pipe through the levee, 11.5 feet below the crown. Flap gate on the waterside (WS) end. Concrete headwall on each end. [Additional Reference(s): DWR Levee Log, 2002. USACE San Joaquin O&M Manual 601.1, 1967, (HLM 1.38)].						
FS Date: 4/16/2014

Pipe, headwall, and flapgate on WS toe.

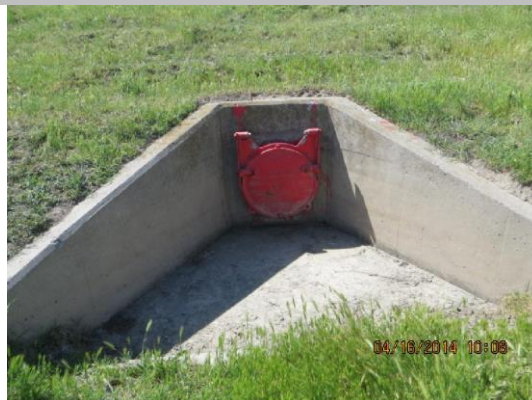
Photo 2 of 3 : UCIP_FA_2019_39510_61093.jpg

Pipe, headwall, and flapgate on WS toe.

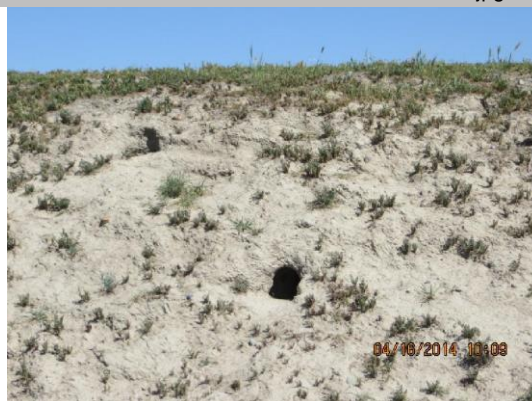
Photo 3 of 3 : UCIP_FA_2019_39510_61095.jpg

LM Start	1.38	Rating **	M	Issue No.	35 (cont)	
LM End	1.38	Issue Type +	Ma	Location *		
Category	Supplemental			GPS Latitude/Longitude		
				Start	End	
Item	DRAFT DWR UCIP LMA Responsibility			37.263194 °	37.263194 °	
				-120.752299 °	-120.752299 °	
DWR ID	19834					
Comment Code						
Inspector Comment						
DS_ID:19834 FS_ID:39510 EP_NO: N/A Repair Type: Non-Urgent Crossing Status: Found UCIP Comments: 04/16/2014 Animal burrows along pipe alignment on LS. Some sediment buildup at LS toe and inside pipe--recommend clearing. (DWR UCIP - W. Wylie) FIELD_STRUCT_DESC: 24-inch corrugated metal gravity drainage pipe through the levee, 11.5 feet below the crown. Flap gate on the waterside (WS) end. Concrete headwall on each end. [Additional Reference(s): DWR Levee Log, 2002. USACE San Joaquin O&M Manual 601.1, 1967, (HLM 1.38)]. FS Date: 4/16/2014

Animal burrows along alignment on LS slope.

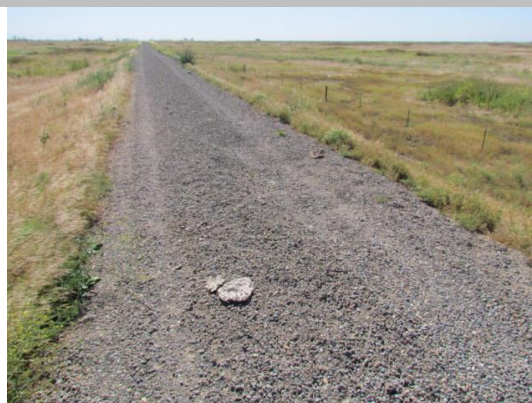
Photo 1 of 1 : FA_2019_NA0010_126_5_20190912_00004.jpg

LM Start	2.01	Rating **	A/W	Issue No.	5
LM End	3.18	Issue Type +	Ma	Location *	CR
Category	Earthen Levee			GPS Latitude/Longitude	
				Start	End
Item	Crown Surface / Depressions / Rutting			37.258410 °	37.251737 °
				-120.743412 °	-120.726246 °
DWR ID	DWR_NA0010_08_s_2016_5				
Comment Code					
C2 : Repair depressions or ruts in the crown or slope.					
Inspector Comment					
A depression is noted on the levee crown.

Looking west at depression on toward landward shoulder.

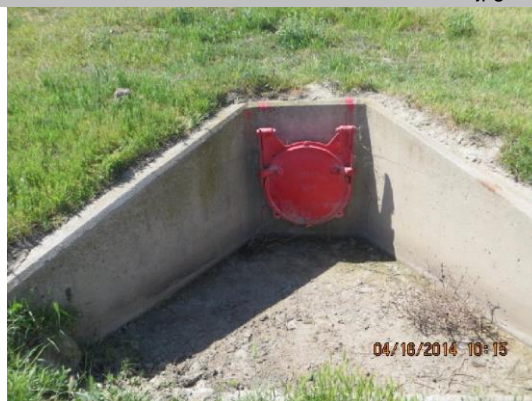
Photo 1 of 3 : UCIP_FA_2019_39511_61098.jpg

LM Start	2.05	Rating **	M	Issue No.	36	
LM End	2.05	Issue Type +	Ma	Location *		
Category	Supplemental			GPS Latitude/Longitude		
				Start	End	
Item	DRAFT DWR UCIP LMA Responsibility			37.258220 °	37.258220 °	
				-120.742868 °	-120.742868 °	
DWR ID	19835					
Comment Code						
Inspector Comment						
DS_ID:19835 FS_ID:39511 EP_NO: N/A Repair Type: Non-Urgent Crossing Status: Found UCIP Comments: 04/16/2014 Non-functional landward inlet is buried in sediment. Need to contact owner to determine status. (DWR UCIP - W. Wylie) FIELD_STRUCT_DESC: 24-inch corrugated metal gravity drainage pipe through the levee, 12 feet below the crown. Flap gate on the waterside (WS) end. Concrete headwall on each end. [Additional Reference(s): DWR Levee Log, 2002. USACE San Joaquin O&M Manual 601.1, 1967, (HLM 2.05)]. FS Date: 4/16/2014

Pipe, headwall, and flapgate on Ws toe.

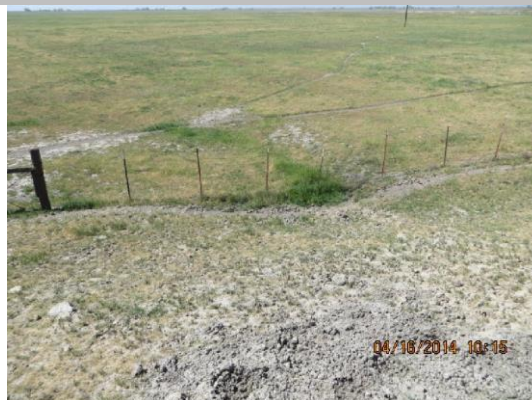
Photo 2 of 3 : UCIP_FA_2019_39511_61099.jpg

Pipe and headwall buried in sediment at LS toe.

LM Start	2.05	Rating **	M	Issue No.	36 (cont)	
LM End	2.05	Issue Type +	Ma	Location *		
Category	Supplemental			GPS Latitude/Longitude		
				Start		End
Item	DRAFT DWR UCIP LMA Responsibility			37.258220 °		37.258220 °
				-120.742868 °		-120.742868 °
DWR ID	19835					
Comment Code						
Inspector Comment						
DS_ID:19835 FS_ID:39511 EP_NO: N/A Repair Type: Non-Urgent Crossing Status: Found UCIP Comments: 04/16/2014 Non-functional landward inlet is buried in sediment. Need to contact owner to determine status. (DWR UCIP - W. Wylie) FIELD_STRUCT_DESC: 24-inch corrugated metal gravity drainage pipe through the levee, 12 feet below the crown. Flap gate on the waterside (WS) end. Concrete headwall on each end. [Additional Reference(s): DWR Levee Log, 2002. USACE San Joaquin O&M Manual 601.1, 1967, (HLM 2.05)]. FS Date: 4/16/2014

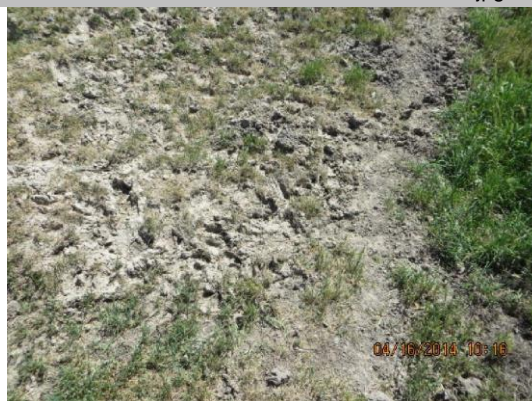
Photo 3 of 3 : UCIP_FA_2019_39511_61097.jpg

Pipe and headwall buried in sediment at LS toe.

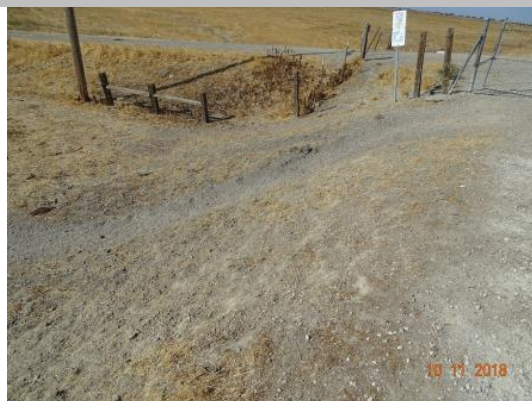
Photo 1 of 1 : FA_2019_NA0010_126_22_20190912_00007.jpg

LM Start	2.07	Rating **	A/W	Issue No.	22
LM End	2.07	Issue Type +	Ma	Location *	LS
Category	Earthen Levee			GPS Latitude/Longitude	
				Start	End
Item	Slope Stability			37.258076 °	37.258076 °
				-120.742439 °	-120.742439 °
DWR ID	DWR_NA0010_08_f_2018_22				
Comment Code					
S2 : Repair the levee slope damaged by foot traffic and prevent access where possible.					
Inspector Comment					
There is damage to the slope and shoulder from livestock.

Slope and shoulder damage from livestock. (Fall 2018)

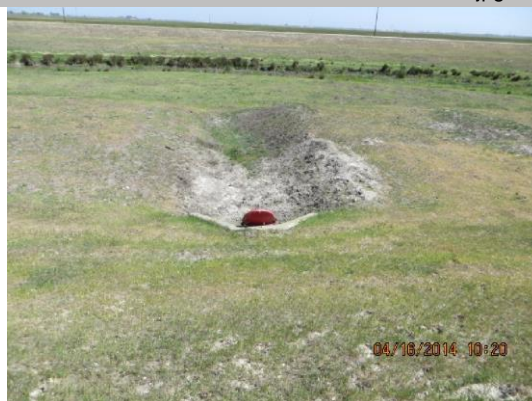
Photo 1 of 3 : UCIP_FA_2019_39512_61102.jpg

LM Start	2.12	Rating **	M	Issue No.	37
LM End	2.12	Issue Type +	Ma	Location *	
Category	Supplemental			GPS Latitude/Longitude	
				Start	End
Item	DRAFT DWR UCIP LMA Responsibility			37.257800 °	37.257800 °
				-120.741604 °	-120.741604 °
DWR ID	19836				
Comment Code					
Inspector Comment					
DS_ID:19836 FS_ID:39512 EP_NO: N/A Repair Type: Non-Urgent Crossing Status: Found UCIP Comments: 04/16/2014 Sediment buildup in pipe visible from landward side. (DWR UCIP - W. Wylie) FIELD_STRUCT_DESC: 24-inch corrugated metal gravity drainage pipe through the levee, 9.5 feet below the crown. Flap gate on the waterside (WS) end. Concrete headwall on each end. [Additional Reference(s): DWR Levee Log, 2002. USACE San Joaquin O&M Manual 601.1, 1967, (HLM 2.12)]. FS Date: 4/16/2014

Pipe, headwall, and flapgate on WS toe.

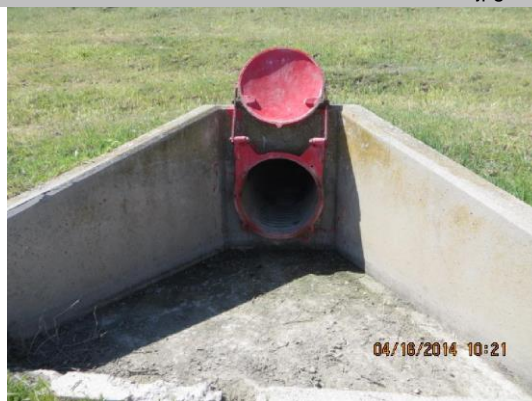
Photo 2 of 3 : UCIP_FA_2019_39512_61100.jpg

Pipe, headwall, and flapgate on WS toe.

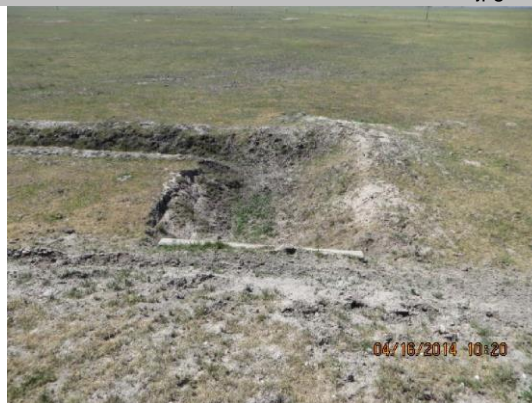
Photo 3 of 3 : UCIP_FA_2019_39512_61101.jpg

Pipe and headwall on LS toe.

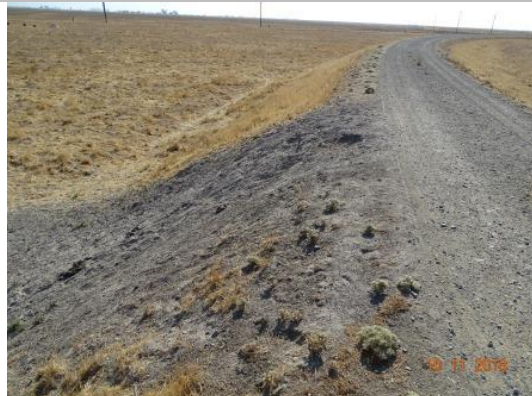
Photo 1 of 1 : FA_2019_NA0010_126_20_20190912_00006.jpg

LM Start	2.74	Rating **	A/W	Issue No.	20
LM End	2.74	Issue Type +	Ma	Location *	LS
Category	Earthen Levee			GPS Latitude/Longitude	
				Start	End
Item	Slope Stability			37.252503 °	37.252503 °
				-120.733282 °	-120.733282 °
DWR ID	DWR_NA0010_08_f_2018_20				
Comment Code					
S2 : Repair the levee slope damaged by foot traffic and prevent access where possible.					
Inspector Comment					
There is minor erosion to the slope and shoulder.

Minor erosion to shoulder and slope from livestock. (Fall 2018)

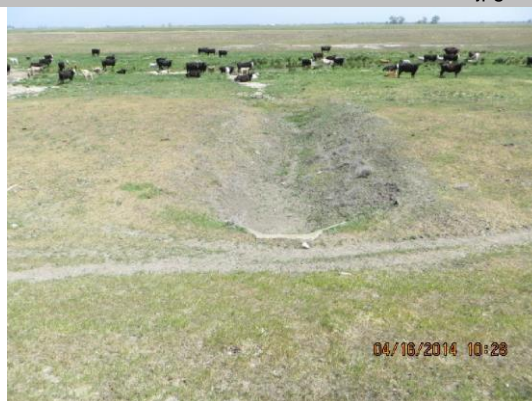
Photo 1 of 3 : UCIP_FA_2019_33760_61107.jpg

LM Start	2.77	Rating **	A/W	Issue No.	38	
LM End	2.77	Issue Type +	Ma	Location *		
Category	Supplemental			GPS Latitude/Longitude		
				Start	End	
Item	DRAFT DWR UCIP LMA Responsibility			37.252228 °	37.252228 °	
				-120.732890 °	-120.732890 °	
DWR ID	19837					
Comment Code						
Inspector Comment						
DS_ID:19837						
FS_ID:33760						
EP_NO: N/A						
Repair Type: No Action Needed						
Crossing Status: Found						
UCIP Comments:						
FIELD_STRUCT_DESC: 24-inch corrugated metal gravity drainage pipe						
through the levee, 10.5 feet below the crown. Flap gate on the						
waterside (WS) end. Concrete headwall on each end. [Additional						
Reference(s): DWR Levee Log, 2002. USACE San Joaquin O&M						
Manual 601.1, 1967, (HLM 2.77)].						
FS Date: 4/16/2014

Pipe, headwall, and flapgate on WS toe.

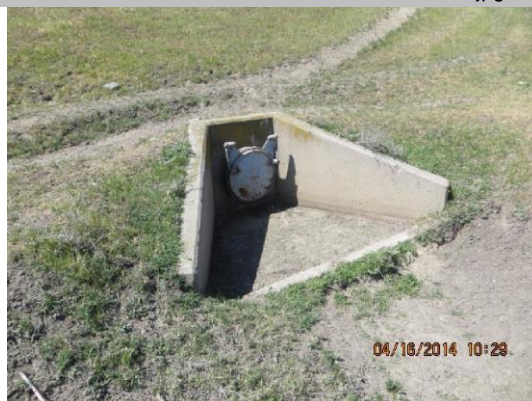
Photo 2 of 3 : UCIP_FA_2019_33760_61105.jpg

Pipe, headwall, and flapgate on WS toe.

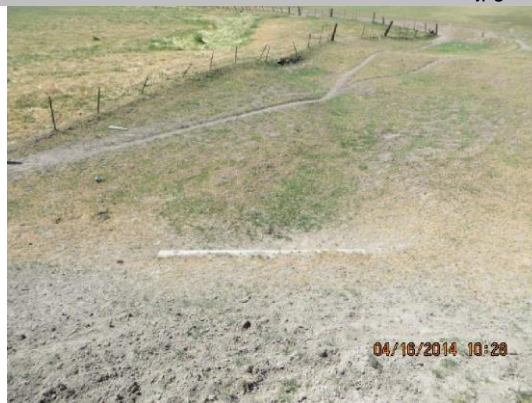
Photo 3 of 3 : UCIP_FA_2019_33760_61106.jpg

Pipe and headwall on LS toe.

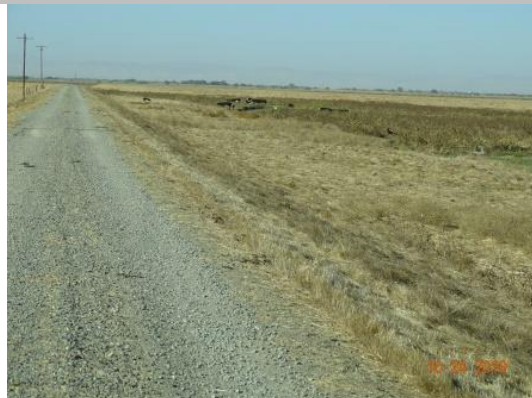
Photo 1 of 1 : FA_2019_NA0010_126_23_20191112_00048.jpg

LM Start	2.89	Rating **	M	Issue No.	23
LM End	3.52	Issue Type +	Ma	Location *	WS
Category	Earthen Levee			GPS Latitude/Longitude	
				Start	End
Item	Vegetation			37.251326°	37.253530°
				-120.731189°	-120.720542°
DWR ID	DWR_NA0010_08_f_2019_23				
Comment Code					
V1 : Control annual grass and weeds on the levee slopes and easements.					
Inspector Comment

View of the waterside slope looking downstream. (Fall 2019)

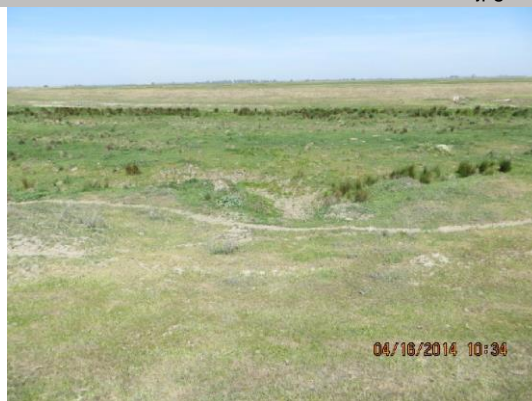
Photo 1 of 3 : UCIP_FA_2019_49969_61112.jpg

Comment Code					
Inspector Comment					
DS_ID:19838					
FS_ID:49969					
EP_NO: N/A					
Repair Type: Non-Urgent					
Crossing Status: Found					
UCIP Comments: 7/20/2016 LS inlet buried under dense vegetation. Dense vegetation limits the inspector's visibility to identify signs of pipe failure (leaks) along the WS and LS slope. Recommend removing vegetation along pipe alignment to conduct proper inspection of structure and appurtenances. (DWR UCIP - omagana)4/16/2014 Pipe blocked by silt on LS toe. Flapgate rusty and does not operate correctly. (DWR UCIP - wwylie)					
FIELD_STRUCT_DESC: 36-inch corrugated metal gravity drainage pipe through the levee, 13.4 feet below the crown. Flap gate on the waterside (WS) end. Concrete headwall on each end. [Additional Reference(s): DWR Levee Log, 2002. USACE San Joaquin O&M Manual 601.1, 1967, (HLM 3.06)].					
FS Date: 7/20/2016

Pipe, headwall, and flapgate on WS toe.

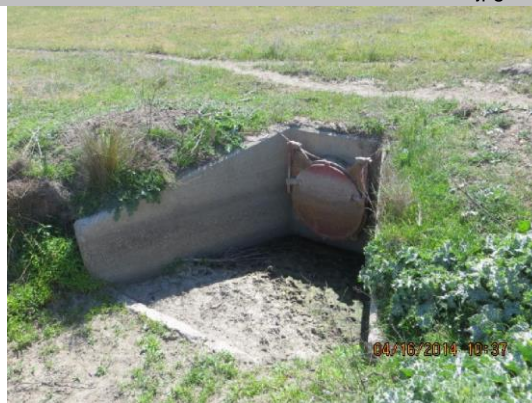
Photo 2 of 3 : UCIP_FA_2019_49969_61113.jpg

Pipe, headwall, and flapgate on WS toe.

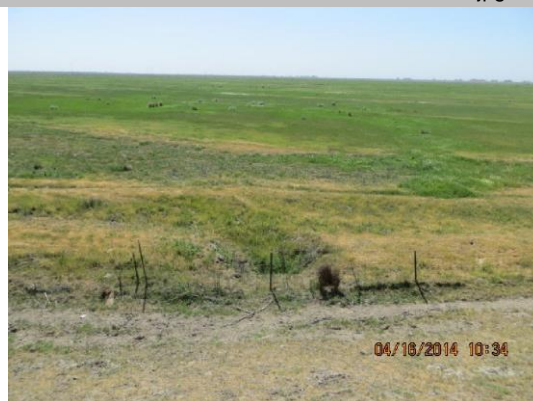
Photo 3 of 3 : UCIP_FA_2019_49969_61111.jpg

Comment Code						
Inspector Comment						
DS_ID:19838 FS_ID:49969 EP_NO: N/A Repair Type: Non-Urgent Crossing Status: Found UCIP Comments: 7/20/2016 LS inlet buried under dense vegetation. Dense vegetation limits the inspector's visibility to identify signs of pipe failure (leaks) along the WS and LS slope. Recommend removing vegetation along pipe alignment to conduct proper inspection of structure and appurtenances. (DWR UCIP - omagana)4/16/2014 Pipe blocked by silt on LS toe. Flapgate rusty and does not operate correctly. (DWR UCIP - wwylie) FIELD_STRUCT_DESC: 36-inch corrugated metal gravity drainage pipe through the levee, 13.4 feet below the crown. Flap gate on the waterside (WS) end. Concrete headwall on each end. [Additional Reference(s): DWR Levee Log, 2002. USACE San Joaquin O&M Manual 601.1, 1967, (HLM 3.06)]. FS Date: 7/20/2016

Pipe and headwall on LS toe.

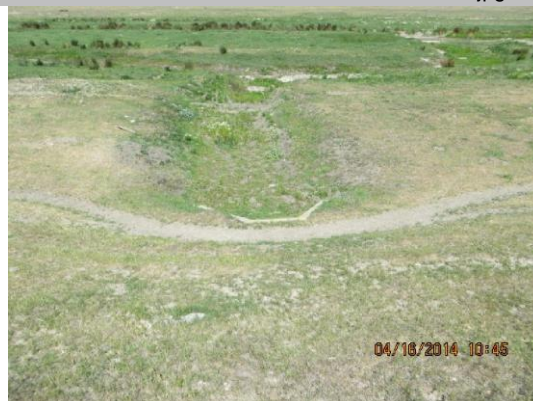
Photo 1 of 3 : UCIP_FA_2019_33764_61128.jpg

LM Start	3.24	Rating **	A/W	Issue No.	40
LM End	3.24	Issue Type +	Ma	Location *	
Category	Supplemental			GPS Latitude/Longitude	
				Start	End
Item	DRAFT DWR UCIP LMA Responsibility			37.252230 °	37.252230 °
				-120.725504 °	-120.725504 °
DWR ID	19839				
Comment Code					
Inspector Comment					
DS_ID:19839 FS_ID:33764 EP_NO: N/A Repair Type: No Action Needed Crossing Status: Found UCIP Comments: FIELD_STRUCT_DESC: 24-inch corrugated metal gravity drainage pipe through the levee, 10 feet below the crown. Flap gate on the waterside (WS) end. Concrete headwall on each end. [Additional Reference(s): DWR Levee Log, 2002. USACE San Joaquin O&M Manual 601.1, 1967, (HLM 3.24)]. FS Date: 4/16/2014

Pipe, flapgate, and headwall on WS toe.

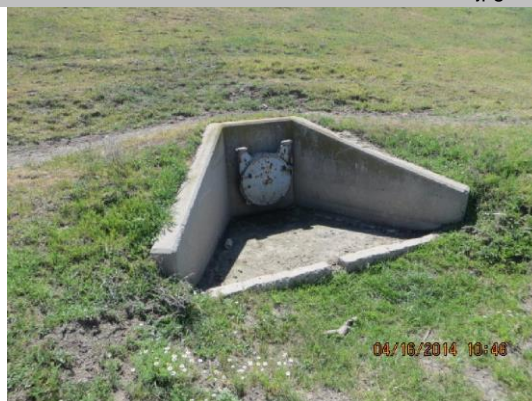
Photo 2 of 3 : UCIP_FA_2019_33764_61127.jpg

Pipe, flapgate, and headwall on WS toe.

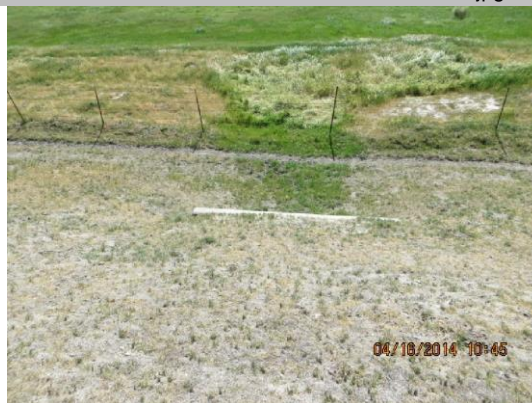
Photo 3 of 3 : UCIP_FA_2019_33764_61129.jpg

Pipe and headwall on LS toe.

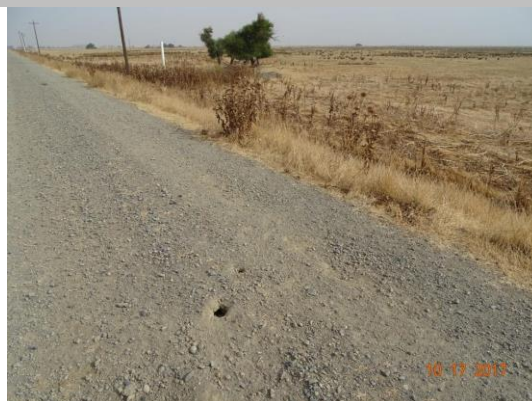
Photo 1 of 2 : FA_2019_NA0010_126_3_20190912_00002.jpg

LM Start	3.40	Rating **	M	Issue No.	3
LM End	3.54	Issue Type +	Ma	Location *	LS
Category	Earthen Levee			GPS Latitude/Longitude	
				Start	End
Item	Animal Control			37.253052°	37.253600°
				-120.722647°	-120.720198°
DWR ID	DWR_NA0010_08_s_2012_3				
Comment Code					
A3 : No rodents visible, but rodent burrows visible; need to backfill and compact or grout burrows.					
Inspector Comment					
Several rodent holes were noted on landside slope within this reach.

Looking east at the crown towards the landside.

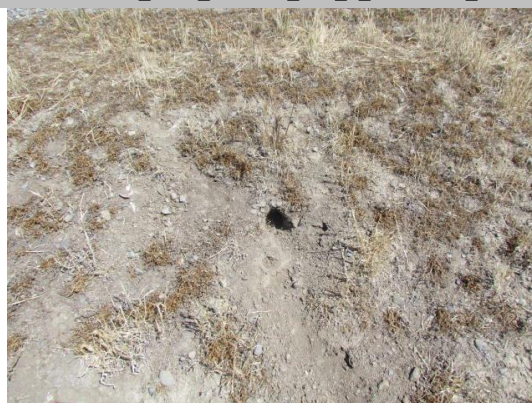
Photo 2 of 2 : FA_2019_NA0010_126_3_20190912_00003.jpg

Looking at typical view of rodent holes on landward slope.

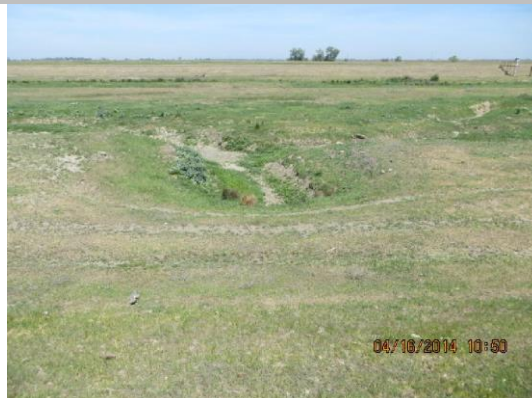
Photo 1 of 3 : UCIP_FA_2019_39513_61134.jpg

LM Start	3.43	Rating **	M	Issue No.	41
LM End	3.43	Issue Type +	Ma	Location *	
Category	Supplemental			GPS Latitude/Longitude	
				Start	End
Item	DRAFT DWR UCIP LMA Responsibility			37.253151°	37.253151°
				-120.722182°	-120.722182°
DWR ID	19840				
Comment Code					
Inspector Comment					
DS_ID:19840 FS_ID:39513 EP_NO: N/A Repair Type: Non-Urgent Crossing Status: Found UCIP Comments: 04/16/2014 No access available on landward side. Need to confirm status of crossing. (DWR UCIP - W. Wylie) FIELD_STRUCT_DESC: 24-inch corrugated metal gravity drainage pipe through the levee, 13 feet below the crown. Flap gate on the waterside (WS) end. Concrete headwall on each end. [Additional Reference(s): DWR Levee Log, 2002. USACE San Joaquin O&M Manual 601.1, 1967, (HLM 3.43)]. FS Date: 4/16/2014

Pipe, headwall, and flapgate on WS toe.

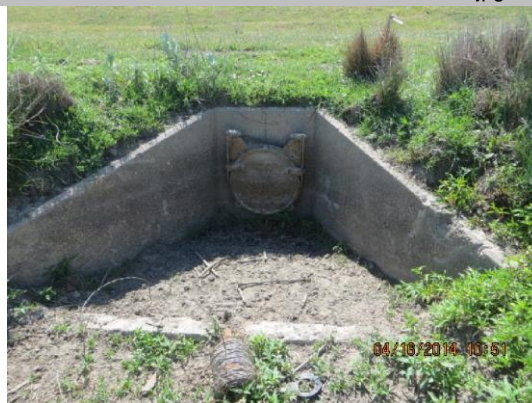
Photo 2 of 3 : UCIP_FA_2019_39513_61133.jpg

Pipe, headwall, and flapgate on WS toe.

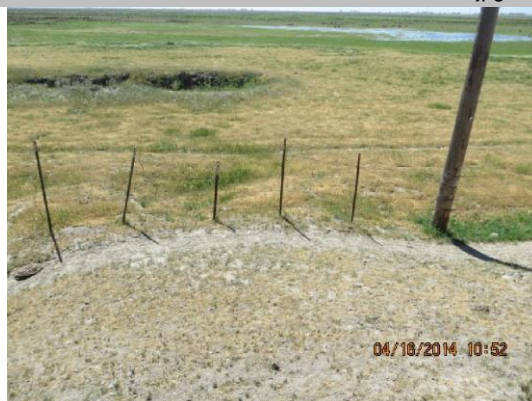
Photo 3 of 3 : UCIP_FA_2019_39513_61132.jpg

Pipe likely at drainage swale off LS toe.

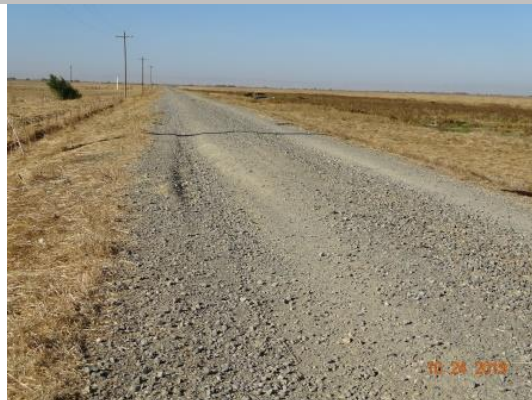
Photo 1 of 1 : FA_2019_NA0010_126_19_20191112_00049.jpg

LM Start	3.49	Rating **	M	Issue No.	19
LM End	3.49	Issue Type +	Ma	Location *	CR
Category	Earthen Levee			GPS Latitude/Longitude	
				Start	End
Item	Crown Surface / Depressions / Rutting			37.253403 °	37.253403 °
				-120.721095 °	-120.721095 °
DWR ID	DWR_NA0010_08_f_2018_19				
Comment Code					
C2 : Repair depressions or ruts in the crown or slope.					
Inspector Comment

View of ruts forming in the levee crown. (Fall 2019)

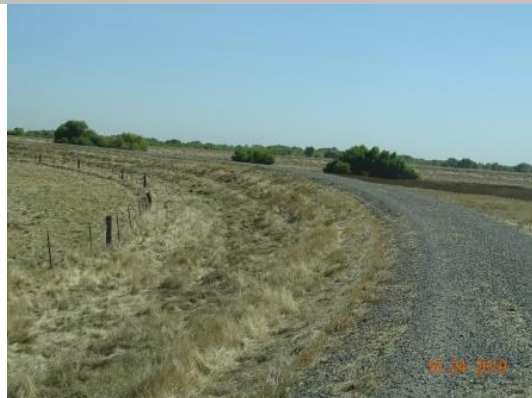
Photo 1 of 1 : FA_2019_NA0010_127_5_20191112_00012.jpg

LM Start	0.02	Rating **	M	Issue No.	5
LM End	0.86	Issue Type +	Ma	Location *	LS
Category	Earthen Levee			GPS Latitude/Longitude	
				Start	End
Item	Vegetation			37.219941°	37.220017°
				-120.712764°	-120.698514°
DWR ID	DWR_NA0010_09_f_2019_5				
Comment Code					
V1 : Control annual grass and weeds on the levee slopes and easements.					
Inspector Comment

View of the landside slope looking upstream. (Fall 2019)

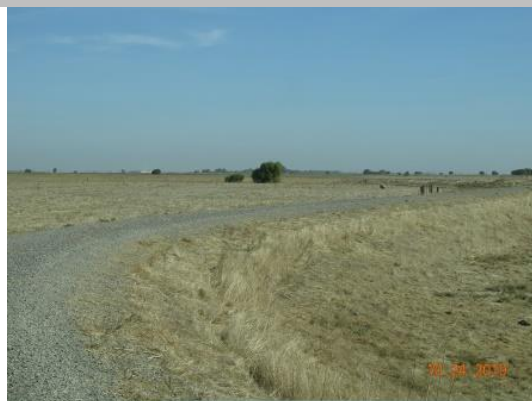
Photo 1 of 1 : FA_2019_NA0010_127_6_20191112_00013.jpg

LM Start	0.22	Rating **	M	Issue No.	6
LM End	0.55	Issue Type +	Ma	Location *	WS
Category	Earthen Levee			GPS Latitude/Longitude	
				Start	End
Item	Vegetation			37.219945 °	37.220592 °
				-120.709675 °	-120.703832 °
DWR ID	DWR_NA0010_09_f_2019_6				
Comment Code					
V1 : Control annual grass and weeds on the levee slopes and easements.					
Inspector Comment

View of the waterside slope looking upstream. (Fall 2019)

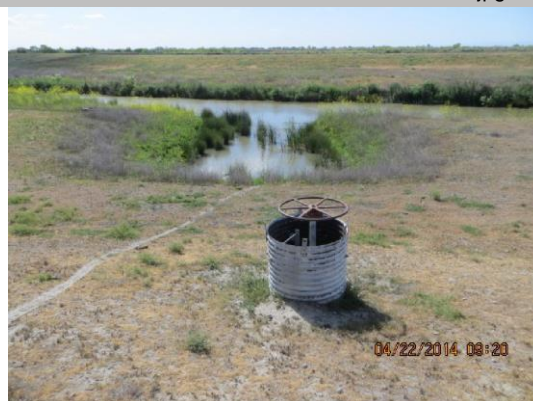
Photo 1 of 3 : UCIP_FA_2019_39888_62119.jpg

Comment Code						
Inspector Comment						
DS_ID:19841 FS_ID:39888 EP_NO: N/A Repair Type: Non-Urgent Crossing Status: Found UCIP Comments: 04/22/2014 Concrete headwalls on landward and waterward under water. Need photo to confirm condition of concrete headwalls, pipe, and gate on both toes. (DWR UCIP - W. Wylie) FIELD_STRUCT_DESC: 24-inch corrugated metal gravity drainage pipe through the levee, 18.7 feet below the crown. Slide gate in a 36-inch corrugated metal pipe (CMP) riser on the waterside (WS) slope. Concrete U-shaped headwall on each end. [Additional Reference(s): DWR Levee Log, 2002. USACE San Joaquin O&M Manual 601.1, 1967, (HLM 0.47)]. FS Date: 4/22/2014

Slide gate in CMP riser on WS slope with outlet visible in background.

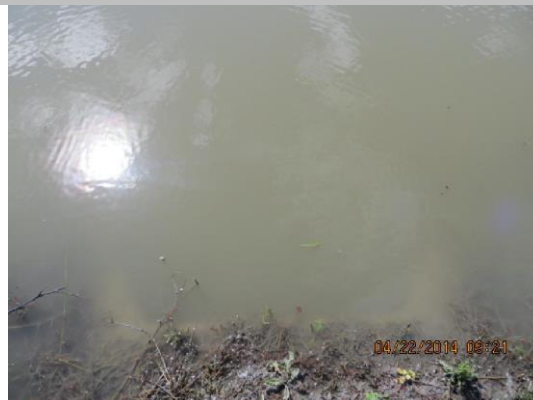
Photo 2 of 3 : UCIP_FA_2019_39888_62117.jpg

Concrete headwall visible under water on WS toe.

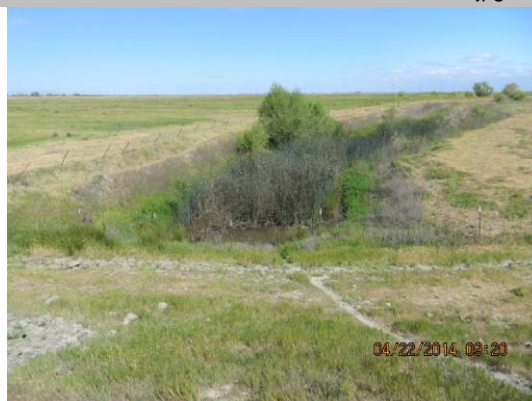
Photo 3 of 3 : UCIP_FA_2019_39888_62118.jpg

Comment Code						
Inspector Comment						
DS_ID:19841 FS_ID:39888 EP_NO: N/A Repair Type: Non-Urgent Crossing Status: Found UCIP Comments: 04/22/2014 Concrete headwalls on landward and waterward under water. Need photo to confirm condition of concrete headwalls, pipe, and gate on both toes. (DWR UCIP - W. Wylie) FIELD_STRUCT_DESC: 24-inch corrugated metal gravity drainage pipe through the levee, 18.7 feet below the crown. Slide gate in a 36-inch corrugated metal pipe (CMP) riser on the waterside (WS) slope. Concrete U-shaped headwall on each end. [Additional Reference(s): DWR Levee Log, 2002. USACE San Joaquin O&M Manual 601.1, 1967, (HLM 0.47)]. FS Date: 4/22/2014

Concrete headwall visible at inlet on LS toe.

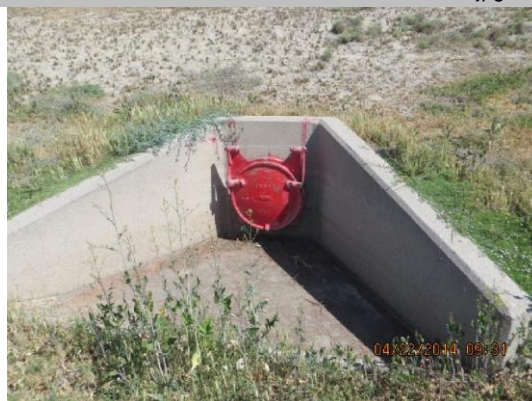
Photo 2 of 3 : UCIP_FA_2019_39515_62132.jpg

Comment Code						
Inspector Comment						
DS_ID:19842 FS_ID:39515 EP_NO: N/A Repair Type: Non-Urgent Crossing Status: Found UCIP Comments: 04/22/2014 Animal burrows in area on LS slope. Minor sediment buildup in pipe visible on landward side--recommend clearing. (DWR UCIP - W. Wylie) FIELD_STRUCT_DESC: 24-inch corrugated metal gravity drainage pipe through the levee, 8.7 feet below the crown. Flap gate on the waterside (WS) end. Concrete headwall on the landside (LS) end. Concrete U-shaped headwall on the WS end. [Additional Reference(s): DWR Levee Log, 2002. USACE San Joaquin O&M Manual 601.1, 1967, (HLM 0.70)]. FS Date: 4/22/2014

Headwall, flapgate, and pipe on WS toe.

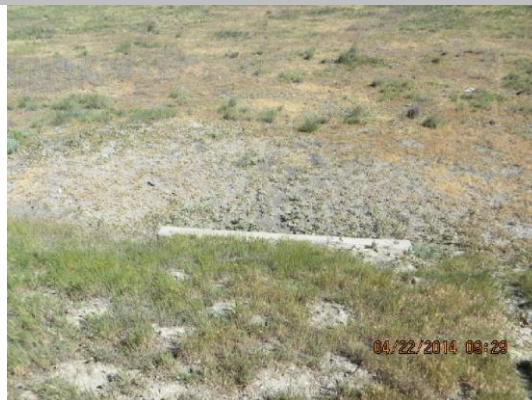
Photo 3 of 3 : UCIP_FA_2019_39515_62129.jpg

Headwall and pipe on LS toe.

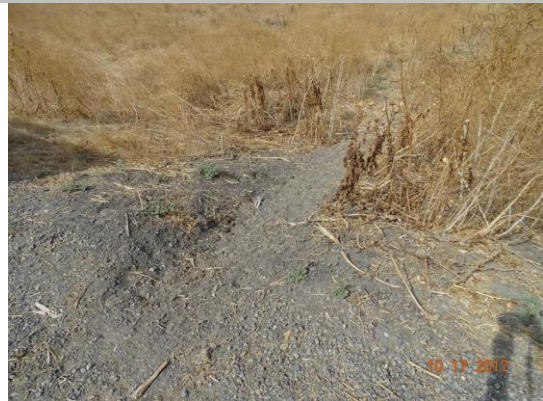
Photo 2 of 2 : FA_2019_NA0010_127_4_20190912_00002.jpg

LM Start	0.86	Rating **	M	Issue No.	4 (cont)
LM End	0.86	Issue Type +	Ma	Location *	LS

Looking northwest at landside slope. (Fall 2017)

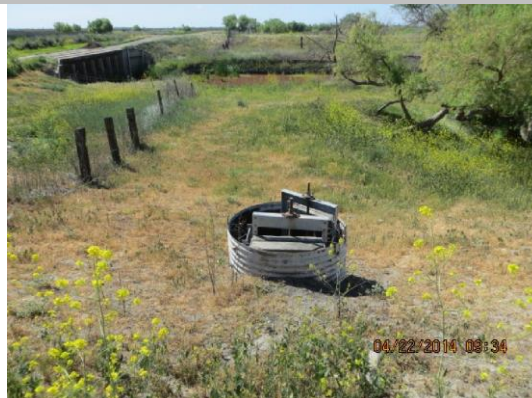
Photo 1 of 3 : UCIP_FA_2019_34186_62134.jpg

Comment Code						
Inspector Comment						
DS_ID:19843						
FS_ID:34186						
EP_NO: N/A						
Repair Type: No Action Needed						
Crossing Status: Found						
UCIP Comments:						
FIELD_STRUCT_DESC: [Crane Irrigation Structure] 24-inch corrugated metal gravity drainage pipe through the levee, 9.7 feet below the crown. Two slide gates in a 48-inch corrugated metal pipe (CMP) riser on the waterside (WS) slope. Concrete U-shaped headwall on the landside (LS) end. WS end cobble revetted on the bank and in the outlet drain. [Additional Reference(s): DWR Levee Log, 2002. USACE San Joaquin O&M Manual 601.1, 1967, (HLM 0.87)].						
FS Date: 4/22/2014

48-inch CMP riser with slide gates on WS slope.

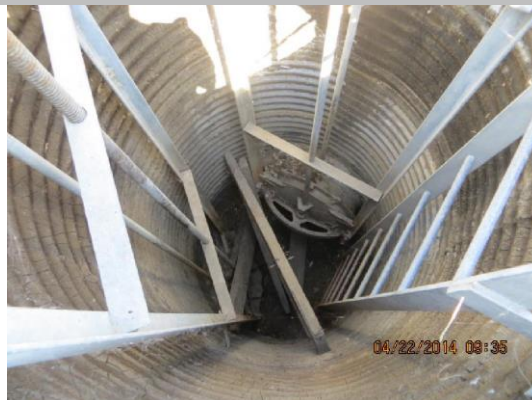
Photo 2 of 3 : UCIP_FA_2019_34186_62133.jpg

Inside CMP riser on WS slope.

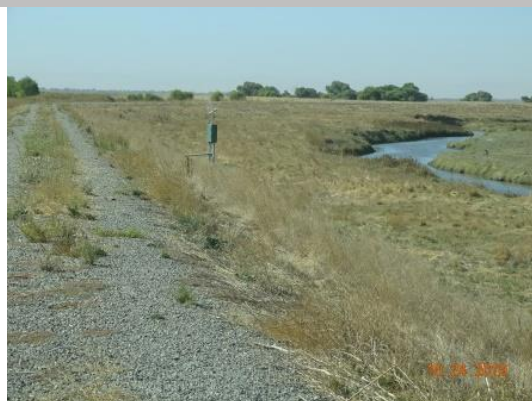
Photo 1 of 1 : FA_2019_NA0010_128_2_20191112_00005.jpg

LM Start	0.10	Rating **	U	Issue No.	2
LM End	0.78	Issue Type +	Ma	Location *	WS
Category	Earthen Levee			GPS Latitude/Longitude	
				Start	End
Item	Vegetation			37.218603 °	37.219328 °
				-120.710004 °	-120.698159 °
DWR ID	DWR_NA0010_10_f_2019_2				
Comment Code					
V1 : Control annual grass and weeds on the levee slopes and easements.					
Inspector Comment

View of the waterside slope looking downstream. (Fall 2019)

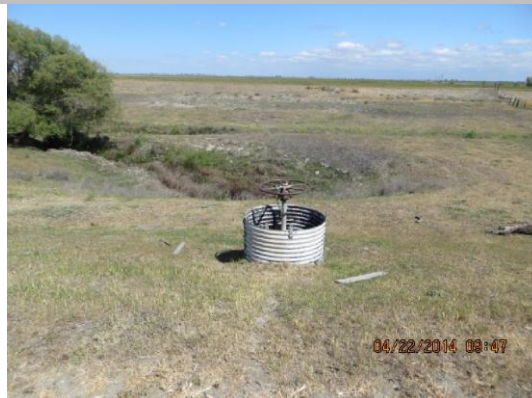
Photo 1 of 3 : UCIP_FA_2019_39516_62144.jpg

LM Start	0.30	Rating **	M	Issue No.	6	
LM End	0.30	Issue Type +	Ma	Location *		
Category	Supplemental			GPS Latitude/Longitude		
				Start	End	
Item	DRAFT DWR UCIP LMA Responsibility			37.219116 °	37.219116 °	
				-120.706652 °	-120.706652 °	
DWR ID	19845					
Comment Code						
Inspector Comment						
DS_ID:19845 FS_ID:39516 EP_NO: N/A Repair Type: Non-Urgent Crossing Status: Found UCIP Comments: 04/22/2014 Inlet blocked at LS toe by wooden gate. Need to contact owner to determine status. (DWR UCIP - W. Wylie) FIELD_STRUCT_DESC: 36-inch corrugated metal gravity drainage pipe through the levee, 19.6 feet below the crown. Slide gate in a 48-inch corrugated metal pipe (CMP) riser on the waterside (WS) slope. Concrete U-shaped headwall on each end. [Additional Reference(s): DWR Levee Log, 2002. USACE San Joaquin O&M Manual 601.1, 1967, (HLM 0.31)]. FS Date: 4/22/2014

Headwall and pipe visible on LS toe. Slide gate inside 48-inch CMP riser on WS slope.

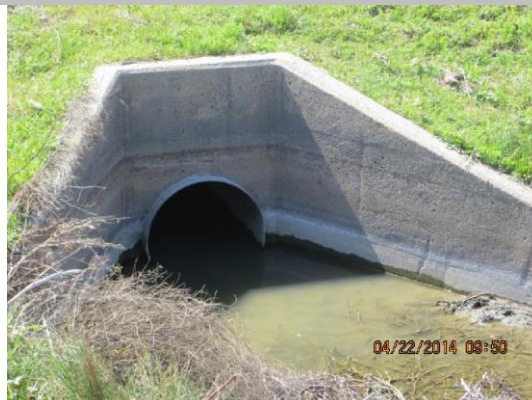
Photo 2 of 3 : UCIP_FA_2019_39516_62146.jpg

Headwall and pipe on WS toe.

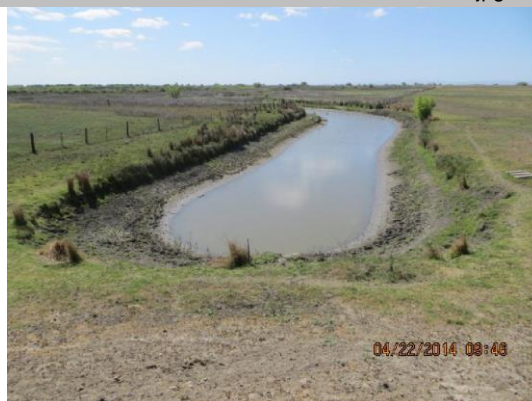
Photo 3 of 3 : UCIP_FA_2019_39516_62145.jpg

LM Start	0.30	Rating **	M	Issue No.	6 (cont)	
LM End	0.30	Issue Type +	Ma	Location *		
Category	Supplemental			GPS Latitude/Longitude		
				Start		End
Item	DRAFT DWR UCIP LMA Responsibility			37.219116 °	37.219116 °	
				-120.706652 °	-120.706652 °	
DWR ID	19845					
Comment Code						
Inspector Comment						
DS_ID:19845 FS_ID:39516 EP_NO: N/A Repair Type: Non-Urgent Crossing Status: Found UCIP Comments: 04/22/2014 Inlet blocked at LS toe by wooden gate. Need to contact owner to determine status. (DWR UCIP - W. Wylie) FIELD_STRUCT_DESC: 36-inch corrugated metal gravity drainage pipe through the levee, 19.6 feet below the crown. Slide gate in a 48-inch corrugated metal pipe (CMP) riser on the waterside (WS) slope. Concrete U-shaped headwall on each end. [Additional Reference(s): DWR Levee Log, 2002. USACE San Joaquin O&M Manual 601.1, 1967, (HLM 0.31)]. FS Date: 4/22/2014

Headwall and pipe on LS toe. Pipe blocked by wooden cover.

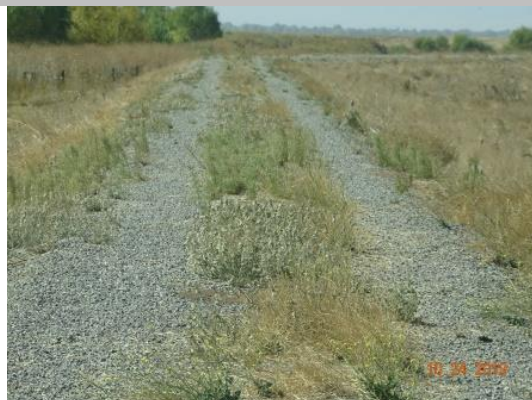
Photo 1 of 1 : FA_2019_NA0010_128_3_20191112_00006.jpg

LM Start	0.71	Rating **	M	Issue No.	3
LM End	0.78	Issue Type +	Ma	Location *	CR
Category	Earthen Levee			GPS Latitude/Longitude	
				Start	End
Item	Vegetation			37.219133°	37.219318°
				-120.699423°	-120.698237°
DWR ID	DWR_NA0010_10_f_2019_3				
Comment Code					
V9 : Keep the crown roadway free of vegetation.					
Inspector Comment

View of vegetation on the levee crown looking downstream. (Fall 2019)

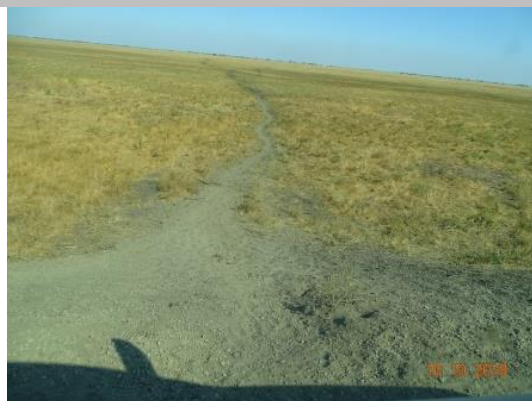
Photo 2 of 2 : FA_2019_NA0010_129_10_20190912_00003.jpg

LM Start	0.16	Rating **	A/W	Issue No.	10 (cont)	
LM End	0.16	Issue Type +	Ma	Location *	LS	
Category	Earthen Levee			GPS Latitude/Longitude		
				Start		End
Item	Slope Stability			37.202730 °		37.202730 °
				-120.752270 °		-120.752270 °
DWR ID	DWR_NA0010_11_f_2018_10					
Comment Code						
S2 : Repair the levee slope damaged by foot traffic and prevent access where possible.						
Inspector Comment						
Slope damage is from livestock crossing.

Looking north down the levee slope. (Fall 2018)

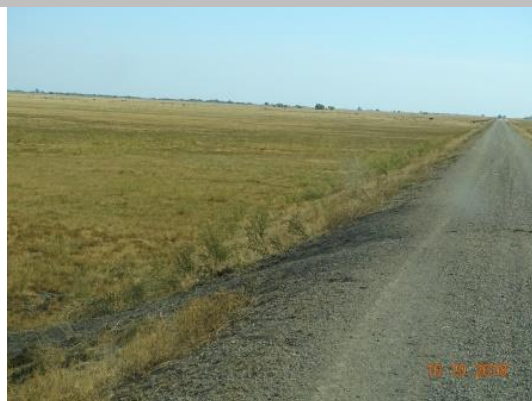
Photo 1 of 2 : FA_2019_NA0010_129_11_20190912_00004.jpg

LM Start	0.21	Rating **	M	Issue No.	11
LM End	0.21	Issue Type +	Ma	Location *	LS
Category	Earthen Levee			GPS Latitude/Longitude	
				Start	End
Item	Slope Stability			37.202731 °	37.202731 °
				-120.751389 °	-120.751389 °
DWR ID	DWR_NA0010_11_f_2018_11				
Comment Code					
S2 : Repair the levee slope damaged by foot traffic and prevent access where possible.					
Inspector Comment					
Damage is from livestock on the land and water side slopes.

View of slope damage on landside. (Fall 2018)

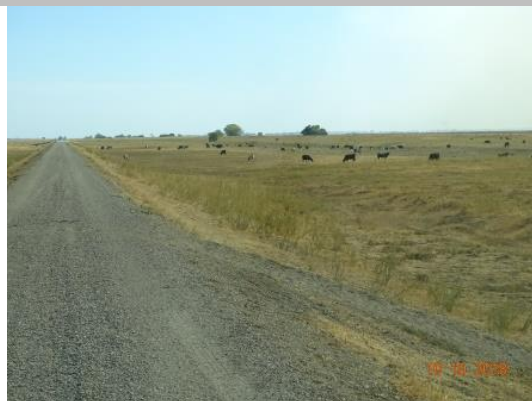
Photo 2 of 2 : FA_2019_NA0010_129_11_20190912_00005.jpg

View of damage on waterside. (Fall 2018)

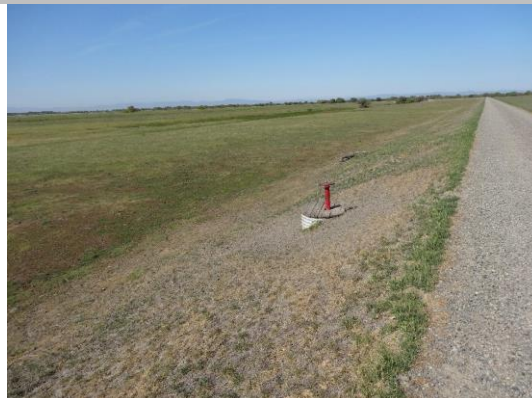
Photo 1 of 3 : UCIP_FA_2019_39517_66644.jpg

LM Start	0.42	Rating **	M	Issue No.	18	
LM End	0.42	Issue Type +	Ma	Location *		
Category	Supplemental			GPS Latitude/Longitude		
				Start		End
Item	DRAFT DWR UCIP LMA Responsibility			37.202754 °		37.202754 °
				-120.747689 °		-120.747689 °
DWR ID	19846					
Comment Code						
Inspector Comment						
DS_ID:19846 FS_ID:39517 EP_NO: N/A Repair Type: Non-Urgent Crossing Status: Found UCIP Comments: 04/18/2014 Need to contact owner. Recommend clearing sediment deposit inside pipe. (DWR UCIP - O. Magana) FIELD_STRUCT_DESC: 24-inch corrugated metal gravity drainage pipe through the levee, 11 feet below the crown. Slide gate in a corrugated metal pipe (CMP) riser on the waterside (WS) end. [Additional Reference(s): DWR Levee Log, 2002. USACE San Joaquin O&M Manual 601.1, 1967, (HLM 0.42)]. FS Date: 4/18/2014

View of slide gate inside CMP riser located on waterward slope.

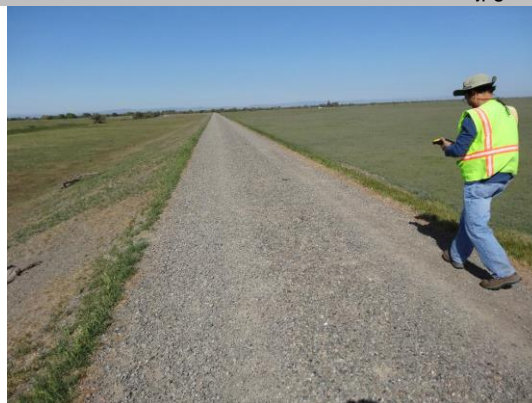
Photo 2 of 3 : UCIP_FA_2019_39517_66643.jpg

View of levee crown at crossing.

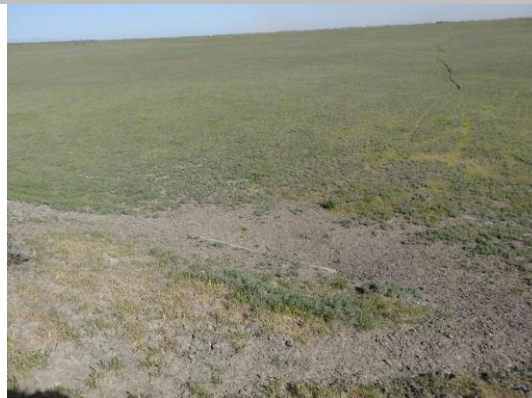
Photo 3 of 3 : UCIP_FA_2019_39517_66642.jpg

LM Start	0.42	Rating **	M	Issue No.	18 (cont)	
LM End	0.42	Issue Type +	Ma	Location *		
Category	Supplemental			GPS Latitude/Longitude		
				Start	End	
Item	DRAFT DWR UCIP LMA Responsibility			37.202754 °	37.202754 °	
				-120.747689 °	-120.747689 °	
DWR ID	19846					
Comment Code						
Inspector Comment						
DS_ID:19846 FS_ID:39517 EP_NO: N/A Repair Type: Non-Urgent Crossing Status: Found UCIP Comments: 04/18/2014 Need to contact owner. Recommend clearing sediment deposit inside pipe. (DWR UCIP - O. Magana) FIELD_STRUCT_DESC: 24-inch corrugated metal gravity drainage pipe through the levee, 11 feet below the crown. Slide gate in a corrugated metal pipe (CMP) riser on the waterside (WS) end. [Additional Reference(s): DWR Levee Log, 2002. USACE San Joaquin O&M Manual 601.1, 1967, (HLM 0.42)]. FS Date: 4/18/2014

View of landward side.

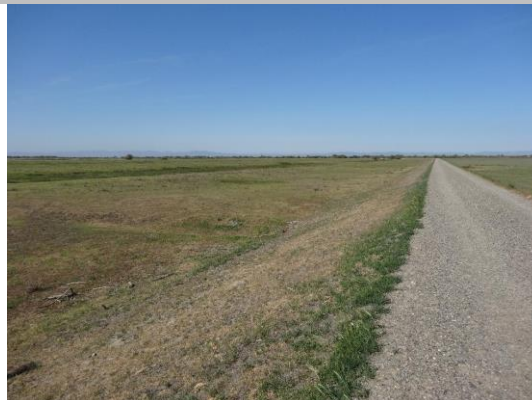
Photo 1 of 3 : UCIP_FA_2019_39518_61997.jpg

LM Start	0.65	Rating **	M	Issue No.	19
LM End	0.65	Issue Type +	Ma	Location *	
Category	Supplemental			GPS Latitude/Longitude	
				Start	End
Item	DRAFT DWR UCIP LMA Responsibility			37.202751 °	37.202751 °
				-120.743474 °	-120.743474 °
DWR ID	19847				
Comment Code					
Inspector Comment					
DS_ID:19847 FS_ID:39518 EP_NO: N/A Repair Type: Non-Urgent Crossing Status: Found UCIP Comments: 04/18/2014 Need to contact owner. Recommend clearing sediment deposit inside pipe. (DWR UCIP - O. Magana) FIELD_STRUCT_DESC: 24-inch corrugated metal gravity drainage pipe through the levee, 10 feet below the crown. Flap gate on the waterside (WS) end. [Additional Reference(s): DWR Levee Log, 2002. USACE San Joaquin O&M Manual 601.1, 1967, (HLM 0.65)]. FS Date: 4/18/2014

View of waterward side.

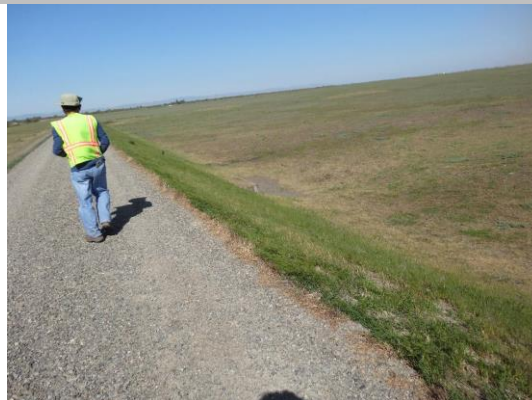
Photo 2 of 3 : UCIP_FA_2019_39518_61996.jpg

LM Start	0.65	Rating **	M	Issue No.	19 (cont)	
LM End	0.65	Issue Type +	Ma	Location *		
Category	Supplemental			GPS Latitude/Longitude		
				Start	End	
Item	DRAFT DWR UCIP LMA Responsibility			37.202751°	37.202751°	
				-120.743474°	-120.743474°	
DWR ID	19847					
Comment Code						
Inspector Comment						
DS_ID:19847						
FS_ID:39518						
EP_NO: N/A						
Repair Type: Non-Urgent						
Crossing Status: Found						
UCIP Comments: 04/18/2014 Need to contact owner. Recommend clearing sediment deposit inside pipe. (DWR UCIP - O. Magana)						
FIELD_STRUCT_DESC: 24-inch corrugated metal gravity drainage pipe through the levee, 10 feet below the crown. Flap gate on the waterside (WS) end. [Additional Reference(s): DWR Levee Log, 2002. USACE San Joaquin O&M Manual 601.1, 1967, (HLM 0.65)].						
FS Date: 4/18/2014

View of landward side.

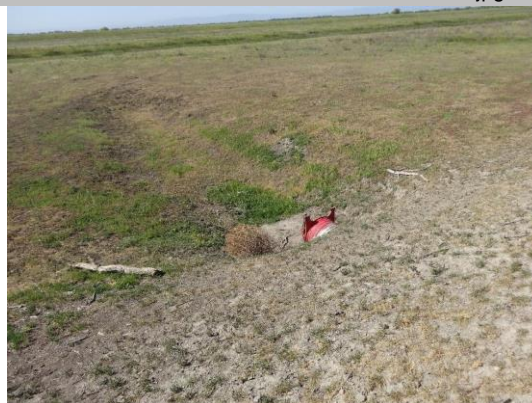
Photo 3 of 3 : UCIP_FA_2019_39518_61999.jpg

Flap gate and concrete apron located on waterward side.

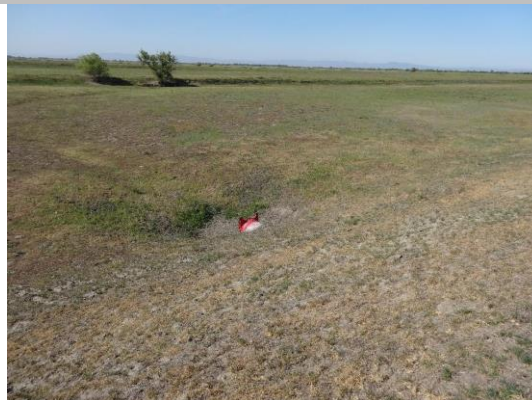
Photo 1 of 3 : UCIP_FA_2019_39519_62003.jpg

LM Start	0.84	Rating **	M	Issue No.	20	
LM End	0.84	Issue Type +	Ma	Location *		
Category	Supplemental			GPS Latitude/Longitude		
				Start	End	
Item	DRAFT DWR UCIP LMA Responsibility			37.202745 °	37.202745 °	
				-120.739935 °	-120.739935 °	
DWR ID	19848					
Comment Code						
Inspector Comment						
DS_ID:19848						
FS_ID:39519						
EP_NO: N/A						
Repair Type: Non-Urgent						
Crossing Status: Found						
UCIP Comments: 04/18/2014 Need to contact owner. Recommend clearing sediment deposit inside pipe. (DWR UCIP - O. Magana)						
FIELD_STRUCT_DESC: 24-inch corrugated metal gravity drainage pipe through the levee, 10.3 feet below the crown. Flap gate on the waterside (WS) end. [Additional Reference(s): DWR Levee Log, 2002. USACE San Joaquin O&M Manual 601.1, 1967, (HLM 0.84)].						
FS Date: 4/18/2014

Overview of waterward side.

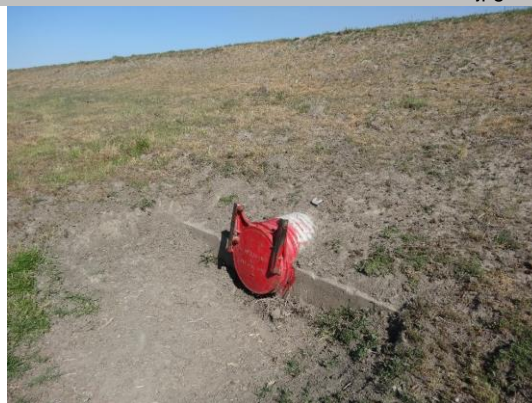
Photo 2 of 3 : UCIP_FA_2019_39519_62002.jpg

Concrete headwall and flap gate visible on waterward side.

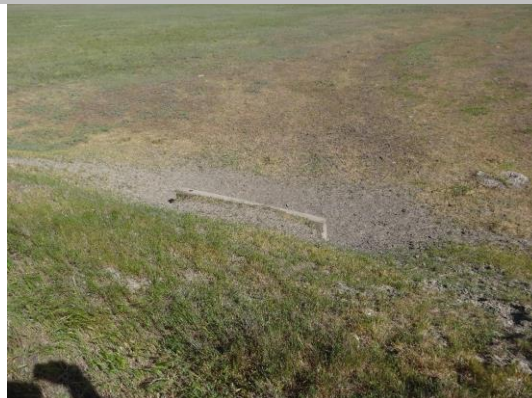
Photo 3 of 3 : UCIP_FA_2019_39519_62001.jpg

LM Start	0.84	Rating **	M	Issue No.	20 (cont)	
LM End	0.84	Issue Type +	Ma	Location *		
Category	Supplemental			GPS Latitude/Longitude		
				Start	End	
Item	DRAFT DWR UCIP LMA Responsibility			37.202745 °	37.202745 °	
				-120.739935 °	-120.739935 °	
DWR ID	19848					
Comment Code						
Inspector Comment						
DS_ID:19848 FS_ID:39519 EP_NO: N/A Repair Type: Non-Urgent Crossing Status: Found UCIP Comments: 04/18/2014 Need to contact owner. Recommend clearing sediment deposit inside pipe. (DWR UCIP - O. Magana) FIELD_STRUCT_DESC: 24-inch corrugated metal gravity drainage pipe through the levee, 10.3 feet below the crown. Flap gate on the waterside (WS) end. [Additional Reference(s): DWR Levee Log, 2002. USACE San Joaquin O&M Manual 601.1, 1967, (HLM 0.84)]. FS Date: 4/18/2014

View of landward side.

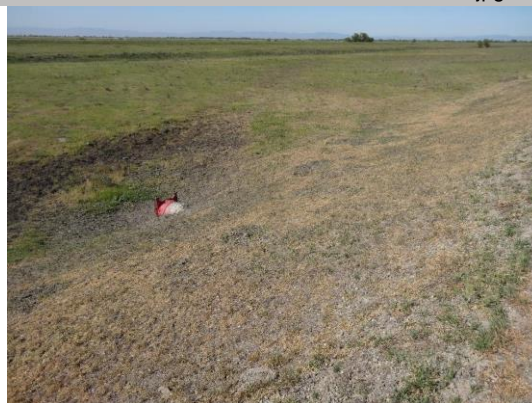
Photo 1 of 3 : UCIP_FA_2019_39520_62008.jpg

LM Start	1.13	Rating **	M	Issue No.	21
LM End	1.13	Issue Type +	Ma	Location *	
Category	Supplemental			GPS Latitude/Longitude	
				Start	End
Item	DRAFT DWR UCIP LMA Responsibility			37.202748 °	37.202748 °
				-120.734796 °	-120.734796 °
DWR ID	19849				
Comment Code					
Inspector Comment					
DS_ID:19849					
FS_ID:39520					
EP_NO: N/A					
Repair Type: Non-Urgent					
Crossing Status: Found					
UCIP Comments: 04/18/2014 Need to contact owner. Recommend clearing sediment deposit inside pipe. (DWR UCIP - O. Magana)					
FIELD_STRUCT_DESC: 24-inch corrugated metal gravity drainage pipe through the levee, 9 feet below the crown. Flap gate on the waterside (WS) end. [Additional Reference(s): DWR Levee Log, 2002. USACE San Joaquin O&M Manual 601.1, 1967, (HLM 1.13)].					
FS Date: 4/18/2014

View of waterward side--flap gate visible at levee toe.

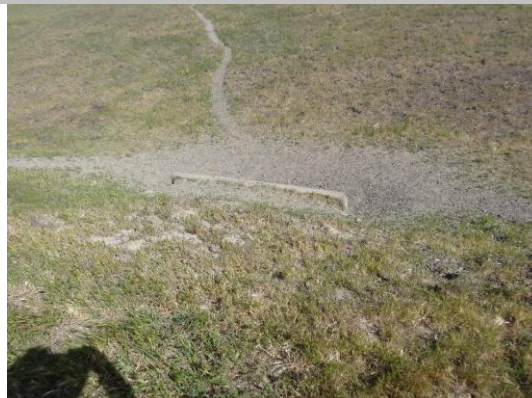
Photo 2 of 3 : UCIP_FA_2019_39520_62007.jpg

View of landward side.

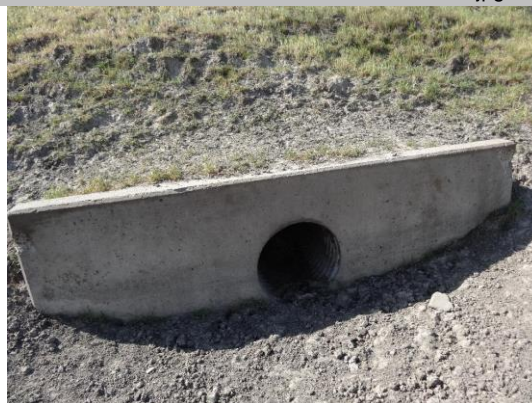
Photo 3 of 3 : UCIP_FA_2019_39520_62006.jpg

Concrete headwall located on landward side.

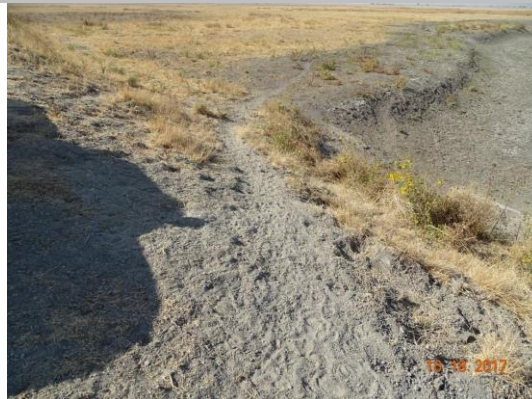
Photo 1 of 1 : FA_2019_NA0010_129_9_20190912_00001.jpg

LM Start	1.49	Rating **	A/W	Issue No.	9							
LM End	1.49	Issue Type +	Ma	Location *	LS							
Category	Earthen Levee		GPS Latitude/Longitude									
			Start	End								
Item	Slope Stability		37.202748 °	37.202748 °								
			-120.728182 °	-120.728182 °								
DWR ID	DWR_NA0010_11_f_2017_9											
Comment Code												
S2 : Repair the levee slope damaged by foot traffic and prevent access where possible.												
Inspector Comment

Looking northwest at landside slope.

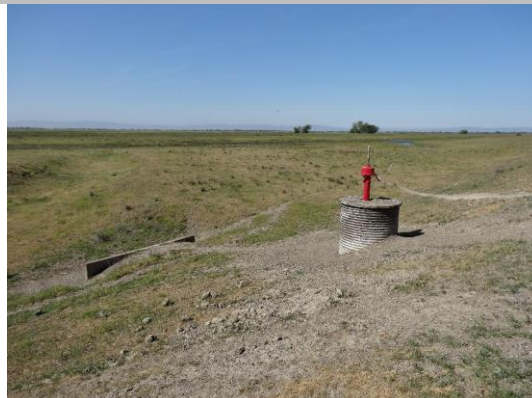
Photo 1 of 3 : UCIP_FA_2019_39521_62018.jpg

LM Start	1.49	Rating **	M	Issue No.	22	
LM End	1.49	Issue Type +	Ma	Location *		
Category	Supplemental			GPS Latitude/Longitude		
				Start	End	
Item	DRAFT DWR UCIP LMA Responsibility			37.202753°	37.202753°	
				-120.728133°	-120.728133°	
DWR ID	19850					
Comment Code						
Inspector Comment						
DS_ID:19850						
FS_ID:39521						
EP_NO: N/A						
Repair Type: Non-Urgent						
Crossing Status: Found						
UCIP Comments: 04/18/2014 Need to contact owner. Recommend clearing sediment deposit inside pipe. (DWR UCIP - O. Magana)						
FIELD_STRUCT_DESC: 48-inch corrugated metal gravity drainage pipe through the levee, 16.3 feet below the crown. Slide gate in a pipe riser on the waterside (WS) slope. [Additional Reference(s): DWR Levee Log, 2002. USACE San Joaquin O&M Manual 601.1, 1967, (HLM 1.50)].						
FS Date: 4/18/2014

View of waterward side.

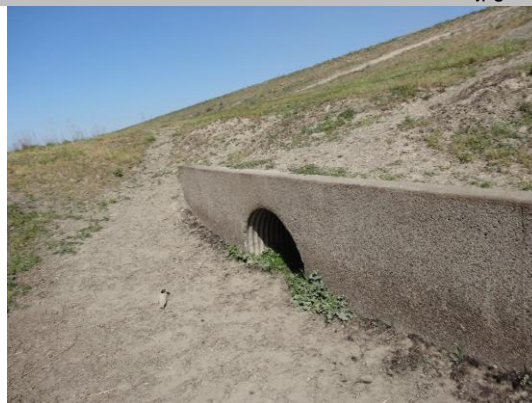
Photo 2 of 3 : UCIP_FA_2019_39521_62017.jpg

View of concrete headwall located on waterward side.

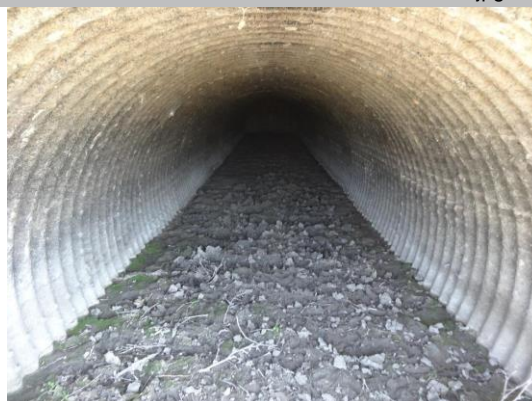
Photo 3 of 3 : UCIP_FA_2019_39521_62016.jpg

Inside view of pipe from waterward side--sediment build up.

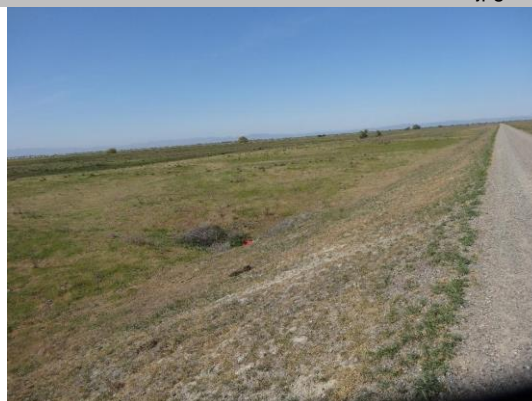
Photo 1 of 3 : UCIP_FA_2019_39522_62024.jpg

LM Start	1.98	Rating **	M	Issue No.	23
LM End	1.98	Issue Type +	Ma	Location *	
Category	Supplemental			GPS Latitude/Longitude	
				Start	End
Item	DRAFT DWR UCIP LMA Responsibility			37.202740 °	37.202740 °
				-120.719247 °	-120.719247 °
DWR ID	19851				
Comment Code					
Inspector Comment					
DS_ID:19851					
FS_ID:39522					
EP_NO: N/A					
Repair Type: Non-Urgent					
Crossing Status: Found					
UCIP Comments: 04/18/2014 Need to contact owner. Recommend clearing sediment deposit inside pipe. (DWR UCIP - O. Magana)					
FIELD_STRUCT_DESC: 24-inch corrugated metal gravity drainage pipe through the levee, 12.8 feet below the crown. Flap gate on the waterside (WS) end. [Additional Reference(s): DWR Levee Log, 2002. USACE San Joaquin O&M Manual 601.1, 1967, (HLM 1.99)].					
FS Date: 4/18/2014

View of waterward side.

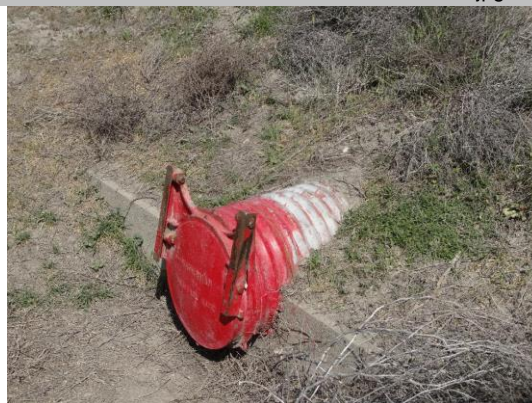
Photo 2 of 3 : UCIP_FA_2019_39522_62025.jpg

Flap gate located on waterward side.
