**Flood Control Project Maintenance
Levee Inspections**

Fall 2019 Levee Maintenance Deficiency Summary Report

San Joaquin River Basin

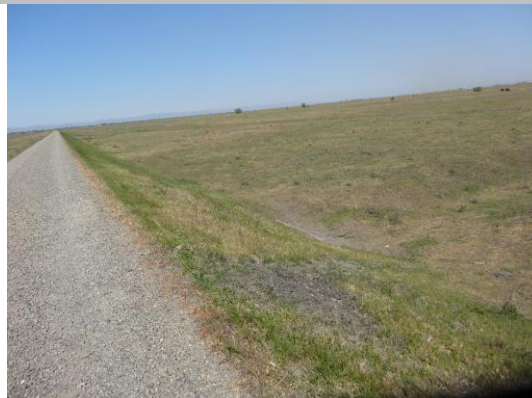
Photo 3 of 3 : UCIP_FA_2019_39522_62023.jpg

View of landward side.

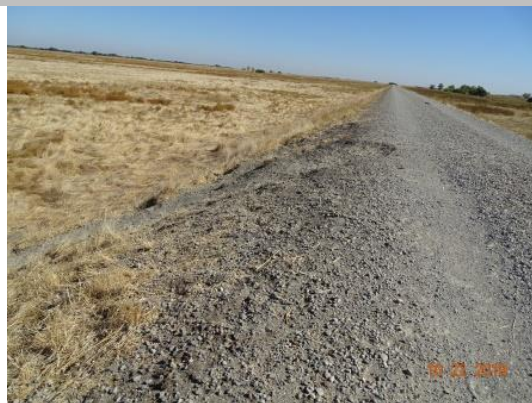
Photo 1 of 1 : FA_2019_NA0010_129_17_20191112_00031.jpg

LM Start	2.31	Rating **	M	Issue No.	17
LM End	2.31	Issue Type +	Ma	Location *	LS
Category	Earthen Levee			GPS Latitude/Longitude	
				Start	End
Item	Slope Stability			37.202730°	37.202730°
				-120.713368°	-120.713368°
DWR ID	DWR_NA0010_11_f_2019_17				
Comment Code					
S2 : Repair the levee slope damaged by foot traffic and prevent access where possible.					
Inspector Comment

Damage to the landside slope from livestock traffic. (Fall 2019)

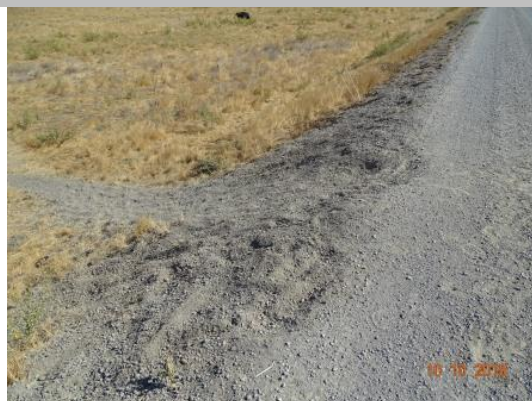
Photo 1 of 2 : FA_2019_NA0010_129_12_20190912_00006.jpg

LM Start	2.46	Rating **	A/W	Issue No.	12
LM End	2.46	Issue Type +	Ma	Location *	LS
Category	Earthen Levee			GPS Latitude/Longitude	
				Start	End
Item	Slope Stability			37.202712°	37.202712°
				-120.710633°	-120.710633°
DWR ID	DWR_NA0010_11_f_2018_12				
Comment Code					
S2 : Repair the levee slope damaged by foot traffic and prevent access where possible.					
Inspector Comment					
Damage is from livestock to both landside and waterside slopes.

View of landside slope. (Fall 2018)

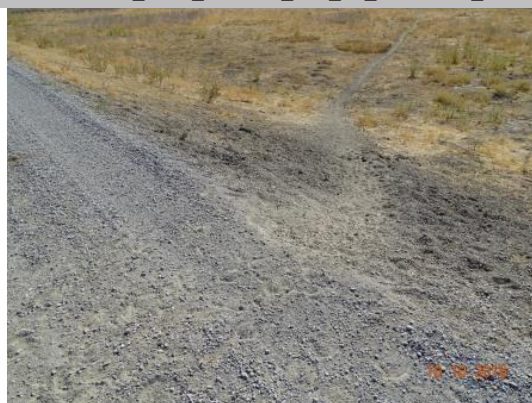
Photo 2 of 2 : FA_2019_NA0010_129_12_20190912_00007.jpg

View of waterside slope. (Fall 2018)

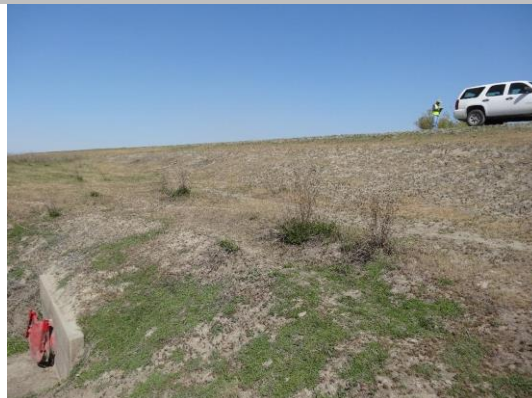
Photo 1 of 3 : UCIP_FA_2019_39523_62028.jpg

LM Start	3.04	Rating **	M	Issue No.	24	
LM End	3.04	Issue Type +	Ma	Location *		
Category	Supplemental			GPS Latitude/Longitude		
				Start	End	
Item	DRAFT DWR UCIP LMA Responsibility			37.202494 °	37.202494 °	
				-120.700153 °	-120.700153 °	
DWR ID	19852					
Comment Code						
Inspector Comment						
DS_ID:19852						
FS_ID:39523						
EP_NO: N/A						
Repair Type: Non-Urgent						
Crossing Status: Found						
UCIP Comments: 04/18/2014 Need to contact owner. Recommend clearing sediment deposit inside pipe. (DWR UCIP - O. Magana)						
FIELD_STRUCT_DESC: 24-inch corrugated metal gravity drainage pipe through the levee, 15 feet below the crown. Flap gate on the waterside (WS) end. [Additional Reference(s): DWR Levee Log, 2002. USACE San Joaquin O&M Manual 601.1, 1967, (HLM 3.04)].						
FS Date: 4/18/2014

Overview of waterward side--flap gate, concrete headwall and apron visible on levee toe.

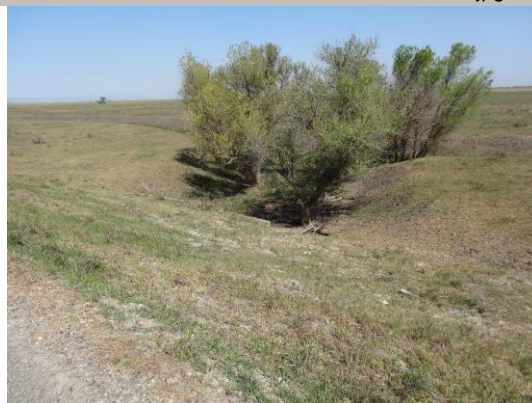
Photo 2 of 3 : UCIP_FA_2019_39523_62027.jpg

View of landward side.

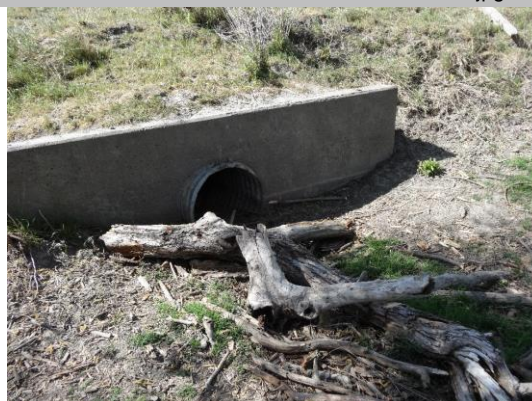
Photo 3 of 3 : UCIP_FA_2019_39523_62030.jpg

Concrete headwall located on landward side--debris in front of headwall.

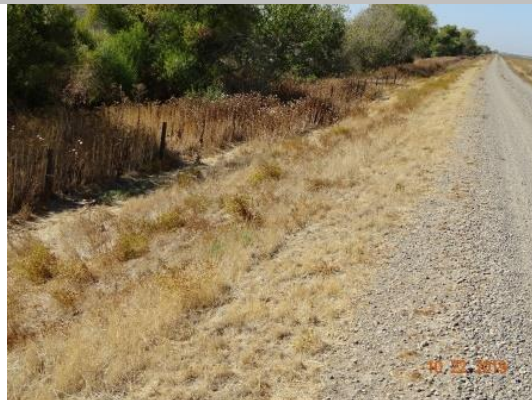
Photo 1 of 1 : FA_2019_NA0010_130_10_20191112_00022.jpg

LM Start	0.01	Rating **	M	Issue No.	10
LM End	3.31	Issue Type +	Ma	Location *	LS
Category	Earthen Levee			GPS Latitude/Longitude	
				Start	End
Item	Vegetation			37.200939 °	37.200949 °
				-120.755016 °	-120.695315 °
DWR ID	DWR_NA0010_12_f_2019_10				
Comment Code					
V1 : Control annual grass and weeds on the levee slopes and easements.					
Inspector Comment

View of the landside slope looking downstream. (Fall 2019)

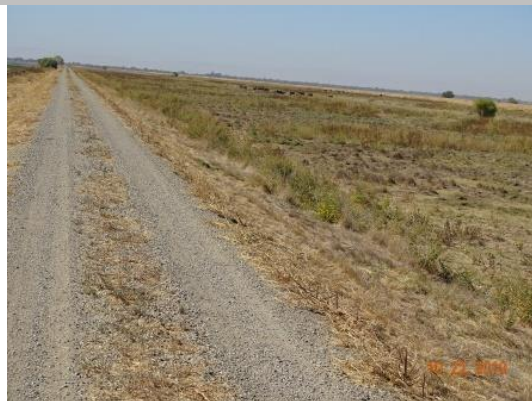
Photo 1 of 1 : FA_2019_NA0010_130_11_20191112_00024.jpg

LM Start	0.01	Rating **	M	Issue No.	11
LM End	3.31	Issue Type +	Ma	Location *	WS
Category	Earthen Levee			GPS Latitude/Longitude	
				Start	End
Item	Vegetation			37.200939 °	37.200949 °
				-120.754987 °	-120.695315 °
DWR ID	DWR_NA0010_12_f_2019_11				
Comment Code					
V1 : Control annual grass and weeds on the levee slopes and easements.					
Inspector Comment

View of the waterside slope looking downstream. (Fall 2019)

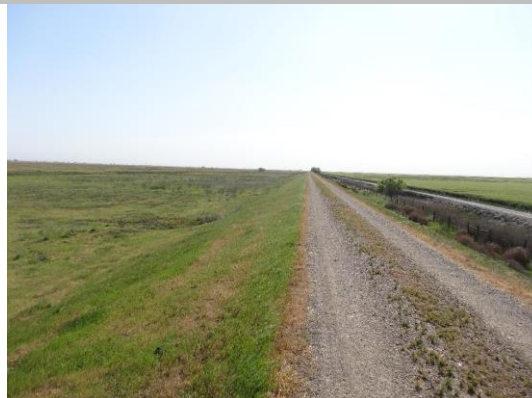
Photo 1 of 3 : UCIP_FA_2019_36704_66647.jpg

Comment Code						
Inspector Comment						
DS_ID:19855 FS_ID:36704 EP_NO: N/A Repair Type: Non-Urgent Crossing Status: Found UCIP Comments: 04/18/2014 Need to contact owner. Dense vegetation limits the inspector's visibility to identify signs of pipe failure (leaks) along the waterward slope. Recommend removing vegetation along pipe alignment to conduct proper inspection of structure. (DWR UCIP - O. Magana) FIELD_STRUCT_DESC: 24-inch corrugated metal gravity drainage pipe through the levee, 10.5 feet below the crown. Flap gate on the waterside (WS) end. [Additional Reference(s): DWR Levee Log, 2002. USACE San Joaquin O&M Manual 601.1, 1967, (HLM 0.39)]. FS Date: 4/18/2014

View of waterward side.

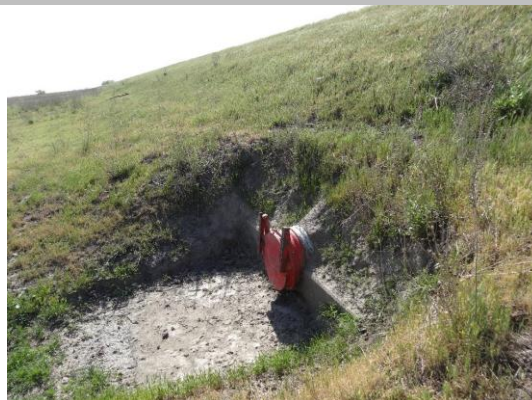
Photo 2 of 3 : UCIP_FA_2019_36704_66649.jpg

Concrete headwall and flap gate visible on waterward side.

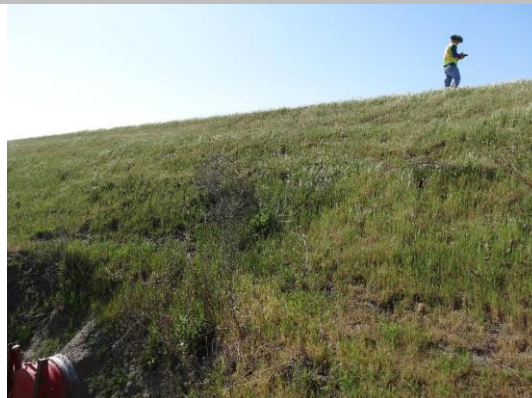
Photo 3 of 3 : UCIP_FA_2019_36704_66648.jpg

Comment Code						
Inspector Comment						
DS_ID:19855						
FS_ID:36704						
EP_NO: N/A						
Repair Type: Non-Urgent						
Crossing Status: Found						
UCIP Comments: 04/18/2014 Need to contact owner. Dense vegetation limits the inspector's visibility to identify signs of pipe failure (leaks) along the waterward slope. Recommend removing vegetation along pipe alignment to conduct proper inspection of structure. (DWR UCIP - O. Magana)						
FIELD_STRUCT_DESC: 24-inch corrugated metal gravity drainage pipe through the levee, 10.5 feet below the crown. Flap gate on the waterside (WS) end. [Additional Reference(s): DWR Levee Log, 2002. USACE San Joaquin O&M Manual 601.1, 1967, (HLM 0.39)].						
FS Date: 4/18/2014

View of waterward side--medium grass throughout slope.

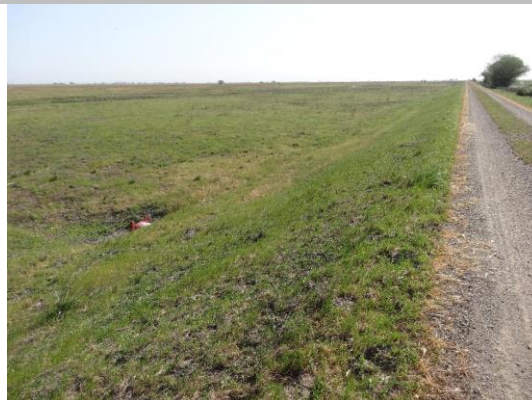
Photo 1 of 3 : UCIP_FA_2019_39889_62048.jpg

LM Start	1.06	Rating **	M	Issue No.	16
LM End	1.06	Issue Type +	Ma	Location *	
Category	Supplemental			GPS Latitude/Longitude	
				Start	End
Item	DRAFT DWR UCIP LMA Responsibility			37.200922 °	37.200922 °
				-120.736012 °	-120.736012 °
DWR ID	19856				
Comment Code					
Inspector Comment					
DS_ID:19856					
FS_ID:39889					
EP_NO: N/A					
Repair Type: Non-Urgent					
Crossing Status: Found					
UCIP Comments: 04/18/2014 Need to contact owner. Recommend clearing sediment deposit inside pipe. (DWR UCIP - O. Magana)					
FIELD_STRUCT_DESC: 24-inch corrugated metal gravity drainage pipe through the levee, 10.5 feet below the crown. Flap gate on the waterside (WS) end. [Additional Reference(s): DWR Levee Log, 2002. USACE San Joaquin O&M Manual 601.1, 1967, (HLM 1.06)].					
FS Date: 4/18/2014

View of waterward side.

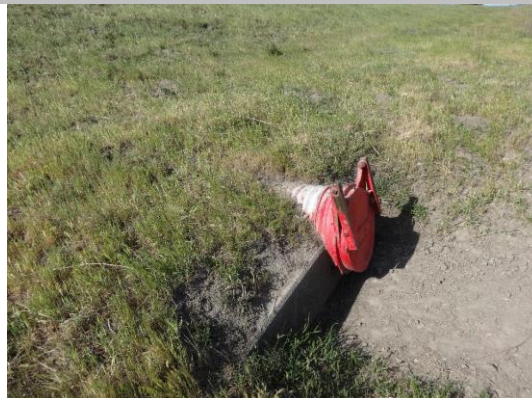
Photo 2 of 3 : UCIP_FA_2019_39889_62049.jpg

Concrete headwall and flap gate visible on waterward side.

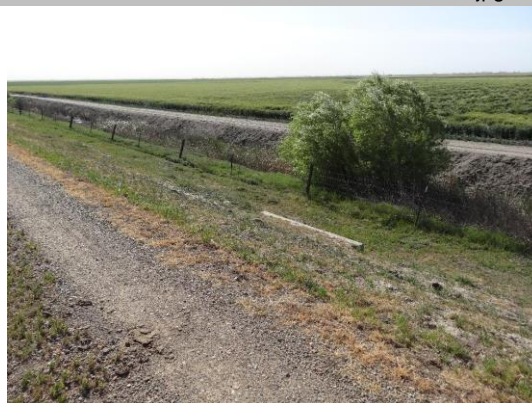
Photo 3 of 3 : UCIP_FA_2019_39889_62047.jpg

View of landward side.

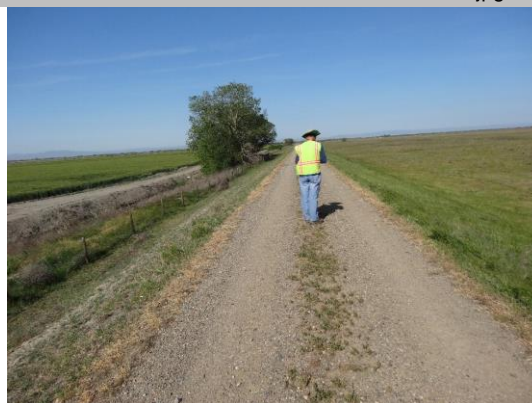
Photo 1 of 3 : UCIP_FA_2019_36705_66654.jpg

Comment Code						
Inspector Comment						
DS_ID:19857						
FS_ID:36705						
EP_NO: N/A						
Repair Type: Non-Urgent						
Crossing Status: Found						
UCIP Comments: 04/18/2014 Landward side not accessible due to dense vegetation and fence. Concrete headwall and flap gate under water therefore not able to evaluate condition. Will need to coordinate with owner to evaluate condition of crossing on waterward side and obtain access to evaluate landward side. (DWR UCIP - O. Magana)						
FIELD_STRUCT_DESC: 24-inch corrugated metal gravity drainage pipe through the levee, 17.4 feet below the crown. Flap gate on the waterside (WS) end. [Additional Reference(s): DWR Levee Log, 2002. USACE San Joaquin O&M Manual 601.1, 1967, (HLM 1.27)].						
FS Date: 4/18/2014

Overview of levee crown at crossing.

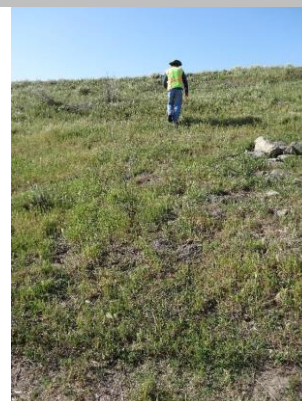
Photo 2 of 3 : UCIP_FA_2019_36705_66652.jpg

View of waterward slope.

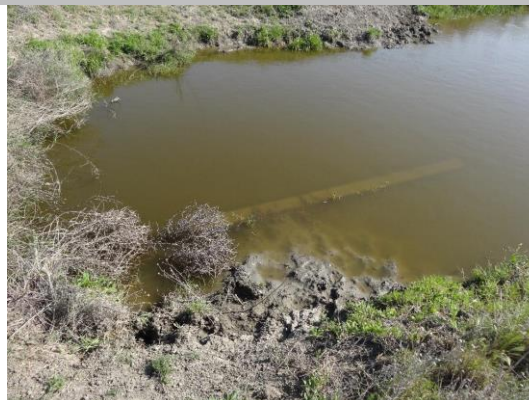
Photo 3 of 3 : UCIP_FA_2019_36705_66653.jpg

View of concrete wall underwater.

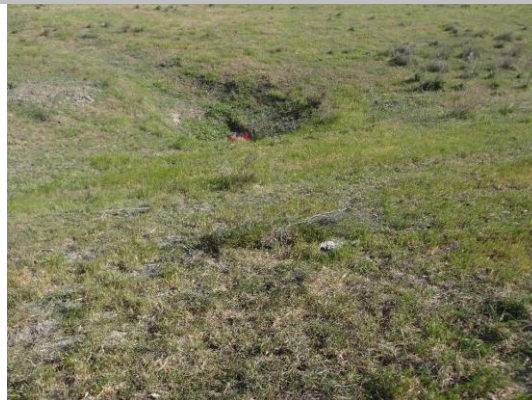
Photo 1 of 3 : UCIP_FA_2019_34126_62060.jpg

LM Start	1.53	Rating **	M	Issue No.	18
LM End	1.53	Issue Type +	Ma	Location *	
Category	Supplemental			GPS Latitude/Longitude	
				Start	End
Item	DRAFT DWR UCIP LMA Responsibility			37.200913 °	37.200913 °
				-120.727496 °	-120.727496 °
DWR ID	19858				
Comment Code					
Inspector Comment					
DS_ID:19858 FS_ID:34126 EP_NO: N/A Repair Type: Non-Urgent Crossing Status: Found UCIP Comments: 04/18/2014 Limited access on landward side due to fence and dense vegetation. Recommend obtaining access to landward side and clear vegetation on landward side. (DWR UCIP - O. Magana) FIELD_STRUCT_DESC: 24-inch corrugated metal gravity drainage pipe through the levee, 10.7 feet below the crown. Flap gate on the waterside (WS) end. [Additional Reference(s): DWR Levee Log, 2002. USACE San Joaquin O&M Manual 601.1, 1967, (HLM 1.53)]. FS Date: 4/18/2014

View of waterward side.

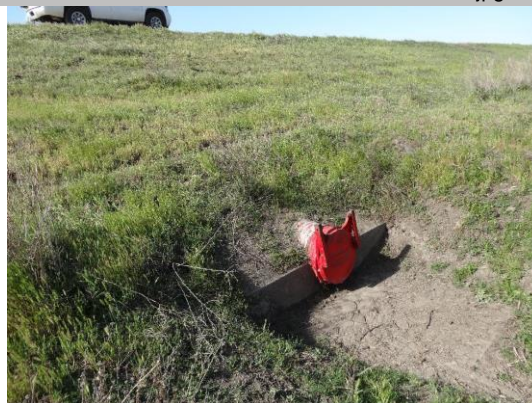
Photo 2 of 3 : UCIP_FA_2019_34126_62061.jpg

Concrete headwall and flap gate visible on waterward side.

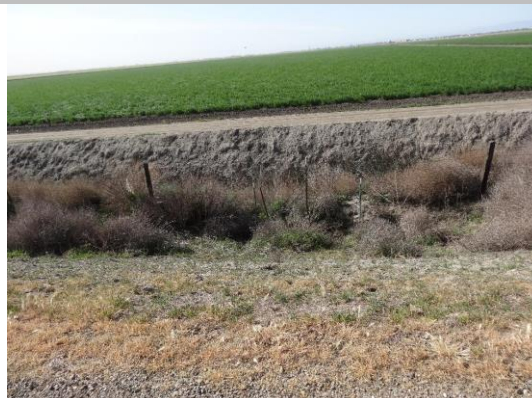
Photo 3 of 3 : UCIP_FA_2019_34126_62059.jpg

View of landward side--limited access due to fence.

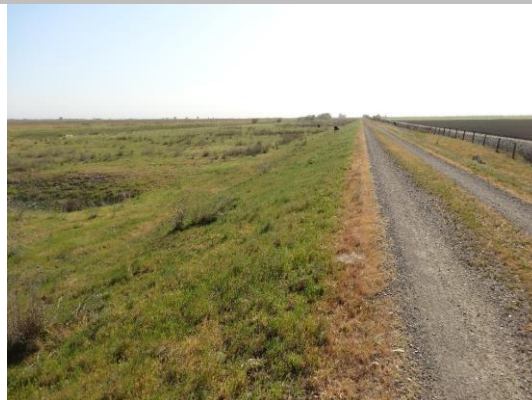
Photo 1 of 3 : UCIP_FA_2019_39506_62064.jpg

LM Start	2.16	Rating **	M	Issue No.	19
LM End	2.16	Issue Type +	Ma	Location *	
Category	Supplemental			GPS Latitude/Longitude	
				Start	End
Item	DRAFT DWR UCIP LMA Responsibility			37.200908 °	37.200908 °
				-120.716118 °	-120.716118 °
DWR ID	19859				
Comment Code					
Inspector Comment					
DS_ID:19859 FS_ID:39506 EP_NO: N/A Repair Type: Non-Urgent Crossing Status: Found UCIP Comments: 04/18/2014 Need to contact owner. Recommend clearing vegetation from landward side--headwall blocked. (DWR UCIP - O. Magana) FIELD_STRUCT_DESC: 24-inch corrugated metal gravity drainage pipe through the levee, 14.4 feet below the crown. Flap gate on the waterside (WS) end. [Additional Reference(s): DWR Levee Log, 2002. USACE San Joaquin O&M Manual 601.1, 1967, (HLM 2.16)]. FS Date: 4/18/2014

View of waterward side.

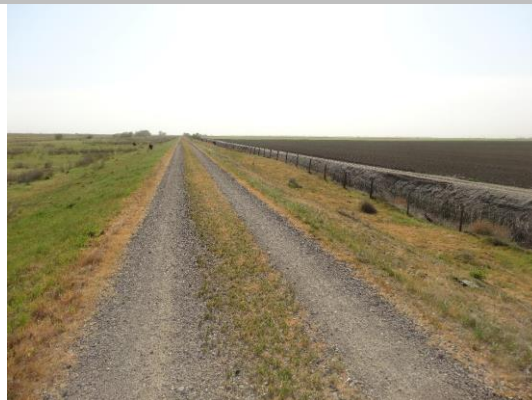
Photo 2 of 3 : UCIP_FA_2019_39506_62063.jpg

Overview of levee crown at crossing.

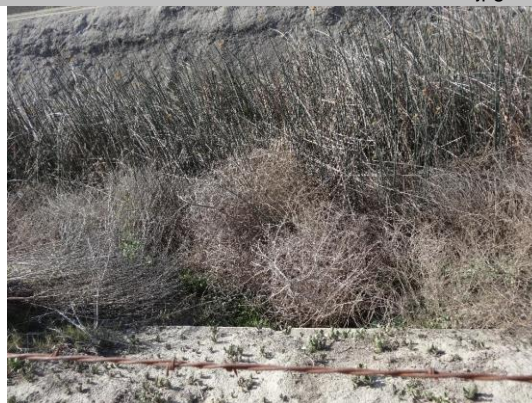
Photo 3 of 3 : UCIP_FA_2019_39506_62062.jpg

Dense vegetation on landward side--limited access due to fence along landward side.

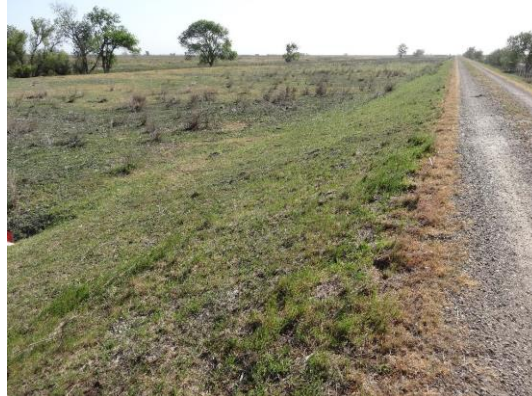
Photo 1 of 3 : UCIP_FA_2019_39890_62069.jpg

LM Start	2.70	Rating **	M	Issue No.	20
LM End	2.70	Issue Type +	Ma	Location *	
Category	Supplemental		GPS Latitude/Longitude		
			Start	End	
Item	DRAFT DWR UCIP LMA Responsibility		37.200906°	37.200906°	
			-120.706316°	-120.706316°	
DWR ID	19860				
Comment Code					
Inspector Comment					
DS_ID:19860 FS_ID:39890 EP_NO: N/A Repair Type: Non-Urgent Crossing Status: Found UCIP Comments: 04/18/2014 Need to contact owner. Recommend clearing sediment deposit inside pipe. (DWR UCIP - O. Magana) FIELD_STRUCT_DESC: 24-inch corrugated metal gravity drainage pipe through the levee, 10.7 feet below the crown. Flap gate on the waterside (WS) end. [Additional Reference(s): DWR Levee Log, 2002. USACE San Joaquin O&M Manual 601.1, 1967, (HLM 2.70)]. FS Date: 4/18/2014

View of waterward side.

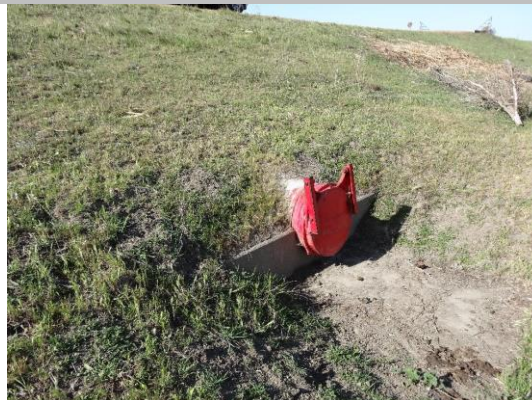
Photo 2 of 3 : UCIP_FA_2019_39890_62070.jpg

Concrete headwall and flat gate located on waterward side.

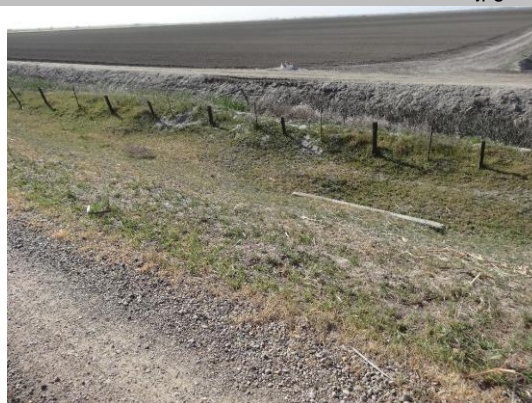
Photo 3 of 3 : UCIP_FA_2019_39890_62068.jpg

View of landward side.

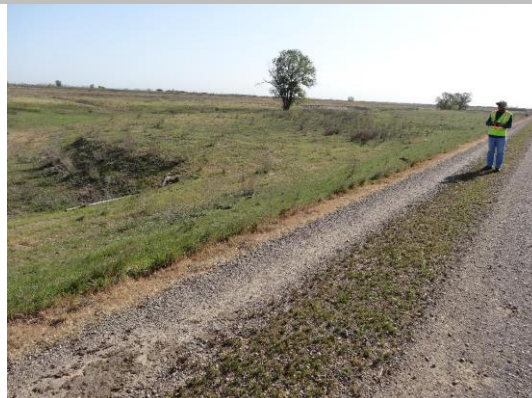
Photo 1 of 3 : UCIP_FA_2019_46786_62073.jpg

Comment Code						
Inspector Comment						
DS_ID:19861 FS_ID:46786 EP_NO: N/A Repair Type: Non-Urgent Crossing Status: Found UCIP Comments: 11/09/2015 DWR Inspection section confirmed issue has been addressed. Need to coordinate with LMA to determine additional details for extent of repair. 04/18/2014 Soil missing behind concrete headwall on waterward side. Unable to determine if missing soil is due to sink holes, rodent activity, or due to erosion. Headwall appears to be leaning slightly forward. Reason why this crossing was labelled urgent was due to the uncertainty of damage to concrete headwall and reason for soil missing behind concrete. Need to coordinate with LMA to determine more information about repair at this location. (DWR UCIP - O. Magana) FIELD_STRUCT_DESC: 24-inch corrugated metal gravity drainage pipe through the levee, 2 feet below the crown. Flap gate on the waterside (WS) end. [Additional Reference(s): DWR Levee Log, 2002. USACE San Joaquin O&M Manual 601.1, 1967, (HLM 3.00)]. FS Date: 11/10/2015 9:29:00 AM

View of waterward side.

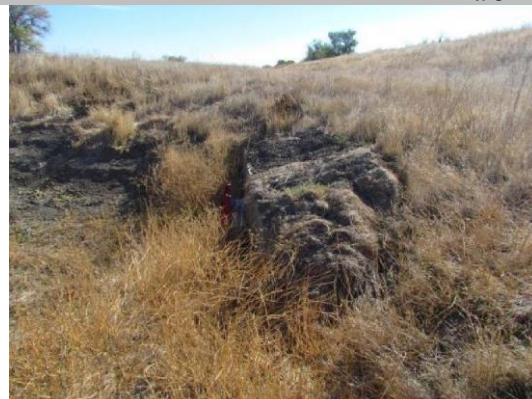
Photo 2 of 3 : UCIP_FA_2019_46786_74729.jpg

Repair to headwall located on waterward side has been addressed.

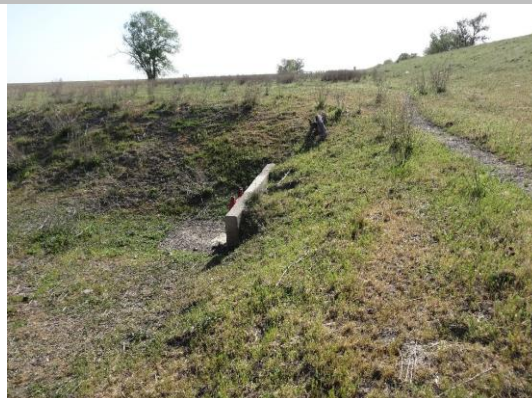
Photo 3 of 3 : UCIP_FA_2019_46786_62072.jpg

Comment Code						
Inspector Comment						
DS_ID:19861 FS_ID:46786 EP_NO: N/A Repair Type: Non-Urgent Crossing Status: Found UCIP Comments: 11/09/2015 DWR Inspection section confirmed issue has been addressed. Need to coordinate with LMA to determine additional details for extent of repair. 04/18/2014 Soil missing behind concrete headwall on waterward side. Unable to determine if missing soil is due to sink holes, rodent activity, or due to erosion. Headwall appears to be leaning slightly forward. Reason why this crossing was labelled urgent was due to the uncertainty of damage to concrete headwall and reason for soil missing behind concrete. Need to coordinate with LMA to determine more information about repair at this location. (DWR UCIP - O. Magana) FIELD_STRUCT_DESC: 24-inch corrugated metal gravity drainage pipe through the levee, 2 feet below the crown. Flap gate on the waterside (WS) end. [Additional Reference(s): DWR Levee Log, 2002. USACE San Joaquin O&M Manual 601.1, 1967, (HLM 3.00)]. FS Date: 11/10/2015 9:29:00 AM

Side view of concrete headwall which appears to be slightly slanted forward--missing soil behind headwall.

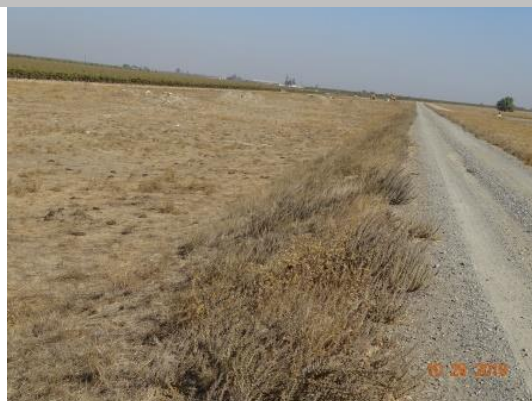
Photo 1 of 1 : FA_2019_NA0010_131_4_20191113_00018.jpg

LM Start	0.01	Rating **	M	Issue No.	4
LM End	0.34	Issue Type +	Ma	Location *	LS
Category	Earthen Levee			GPS Latitude/Longitude	
				Start	End
Item	Vegetation			37.033798 °	37.038351 °
				-120.442095 °	-120.440170 °
DWR ID	DWR_NA0010_13_f_2019_4				
Comment Code					
V1 : Control annual grass and weeds on the levee slopes and easements.					
Inspector Comment

View of the landside slope looking upstream. (Fall 2019)

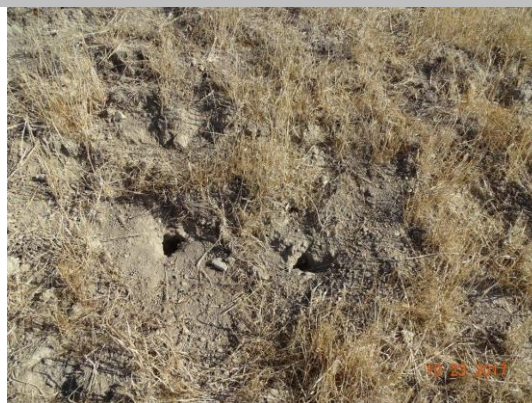
Photo 1 of 1 : FA_2019_NA0010_131_3_20190912_00001.jpg

LM Start	0.15	Rating **	M	Issue No.	3
LM End	0.15	Issue Type +	Ma	Location *	LS
Category	Earthen Levee			GPS Latitude/Longitude	
				Start	End
Item	Animal Control			37.035760 °	37.035760 °
				-120.441282 °	-120.441282 °
DWR ID	DWR_NA0010_13_s_2012_3				
Comment Code					
A3 : No rodents visible, but rodent burrows visible; need to backfill and compact or grout burrows.					
Inspector Comment

Looking at the landside slope.

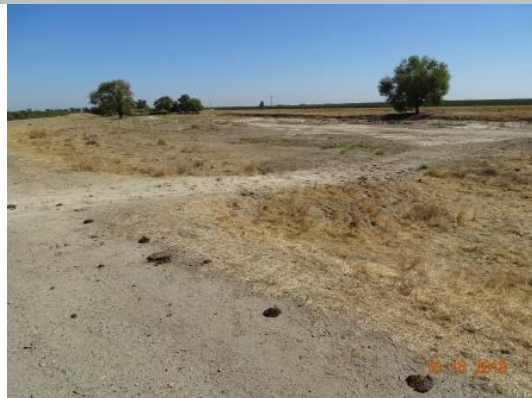
Photo 1 of 3 : FA_2019_NA0010_131_5_20190912_00002.jpg

LM Start	0.91	Rating **	M	Issue No.	5 (cont)
LM End	0.91	Issue Type +	En	Location *	WS

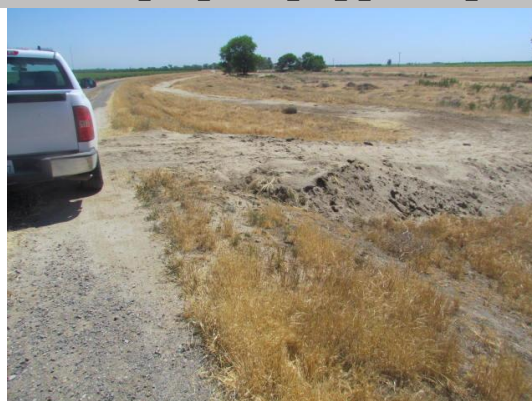
Photo 2 of 3 : FA_2019_NA0010_131_5_20190912_00003.jpg

Looking east at unauthorized ramp on waterward slope.

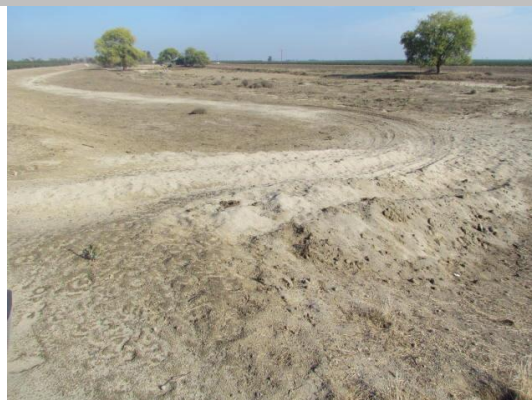
Photo 3 of 3 : FA_2019_NA0010_131_5_20190912_00004.jpg

Looking at unauthorized ramp on waterward slope. (Fall 2014)

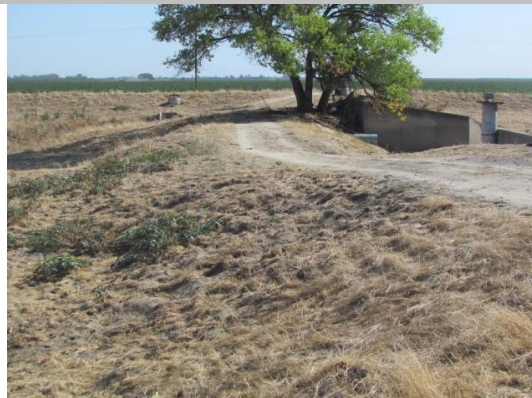
Photo 1 of 6 : FA_2019_NA0010_131_6_20190912_00005.jpg

LM Start	1.14	Rating **	U	Issue No.	6
LM End	1.14	Issue Type +	En	Location *	WS
Category	Earthen Levee			GPS Latitude/Longitude	
				Start	End
Item	Encroachments			37.045541 °	37.045541 °
				-120.430014 °	-120.430014 °
DWR ID	DWR_NA0010_13_f_2015_6				
Comment Code					
WL : Wall					
Inspector Comment					
Sand dam may have been blown out due to high flows in 2017 but has been restored.

Looking overview of sand dam.

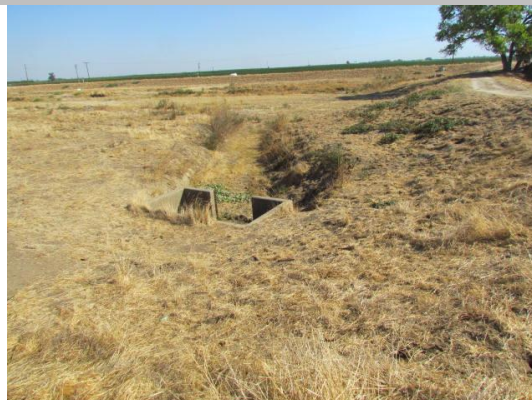
Photo 2 of 6 : FA_2019_NA0010_131_6_20190912_00006.jpg

Looking west at upstream side of sand dam on the southside of the drop structure.

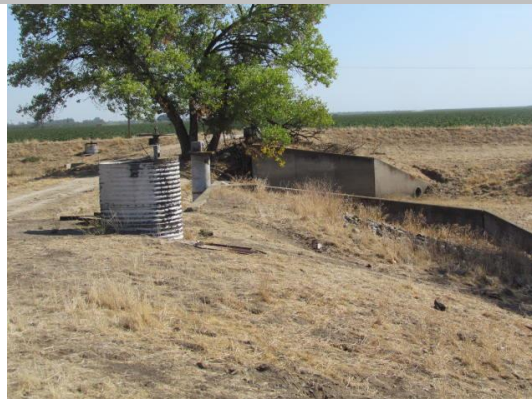
Photo 3 of 6 : FA_2019_NA0010_131_6_20190912_00007.jpg

Looking south at downstream side of structure.

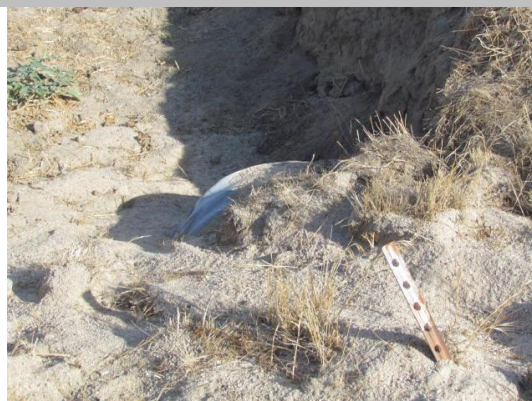
Photo 4 of 6 : FA_2019_NA0010_131_6_20190912_00008.jpg

Looking at corrugated pipe on north end on upstream side of structure.

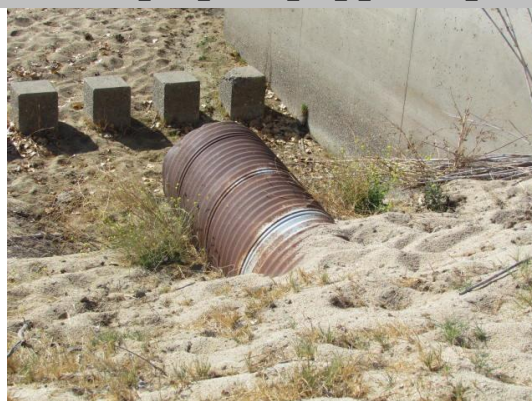
Photo 5 of 6 : FA_2019_NA0010_131_6_20190912_00009.jpg

Looking at corrugated pipe on north end on downstream side of structure.

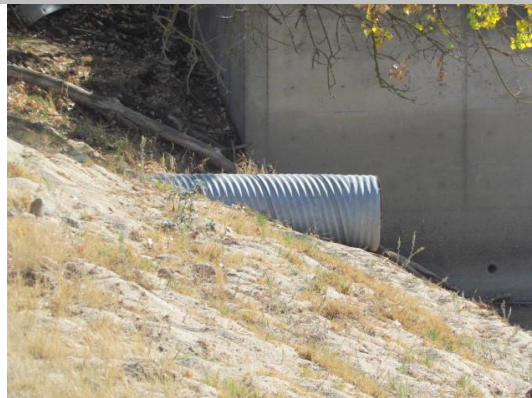
Photo 6 of 6 : FA_2019_NA0010_131_6_20190912_00010.jpg

Looking at corrugated pipe on south end on downstream side of structure.

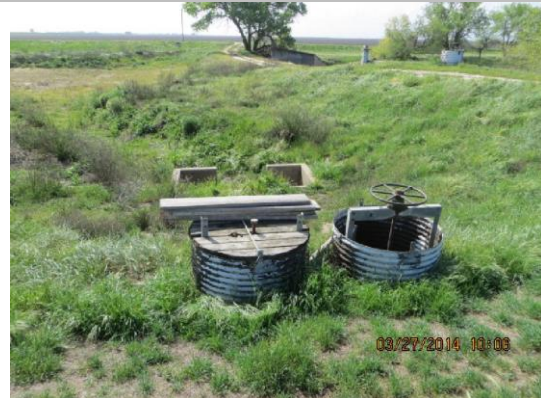
Photo 1 of 3 : UCIP_FA_2019_39877_59385.jpg

Comment Code						
Inspector Comment						
DS_ID:19727 FS_ID:39877 EP_NO: N/A Repair Type: Non-Urgent Crossing Status: Found UCIP Comments: 03/27/2014 Appears abandoned and if so should be done so properly. Pipe filled with soil on WS at outlet. Actuator missing from slide gate on WS shoulder. (DWR UCIP - W. Wylie) FIELD_STRUCT_DESC: [Rounder Irrigation Structure] 1 of 2: 36-inch corrugated metal gravity drainage pipe through the levee, 12.3 feet below the crown. Slide gate in a 48-inch corrugated metal pipe (CMP) riser on the waterside (WS) slope. 6-foot by 12-foot concrete distribution box on the landside (LS). 7-foot by 14-foot concrete outlet structure on the WS toe. [Additional Reference(s): DWR Levee Log, 2002. USACE San Joaquin O&M Manual 601.1, 1967, (HLM 1.14)]. FS Date: 3/27/2014

Slide gate in CMP riser on WS shoulder.

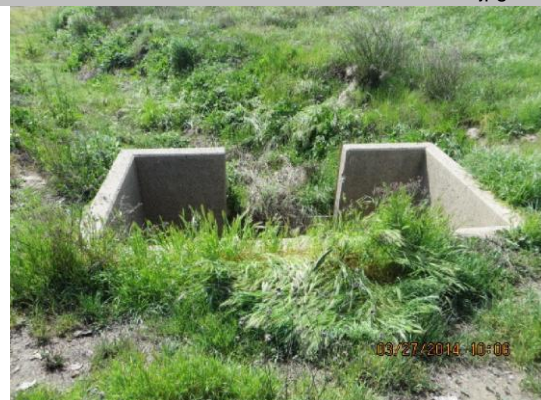
Photo 2 of 3 : UCIP_FA_2019_39877_59384.jpg

Concrete box on WS toe.

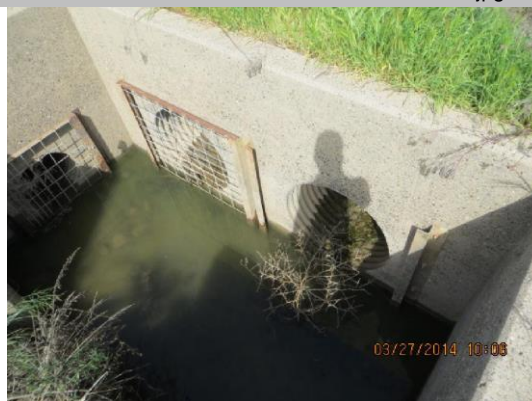
Photo 3 of 3 : UCIP_FA_2019_39877_59389.jpg

Comment Code						
Inspector Comment						
DS_ID:19727 FS_ID:39877 EP_NO: N/A Repair Type: Non-Urgent Crossing Status: Found UCIP Comments: 03/27/2014 Appears abandoned and if so should be done so properly. Pipe filled with soil on WS at outlet. Actuator missing from slide gate on WS shoulder. (DWR UCIP - W. Wylie) FIELD_STRUCT_DESC: [Rounder Irrigation Structure] 1 of 2: 36-inch corrugated metal gravity drainage pipe through the levee, 12.3 feet below the crown. Slide gate in a 48-inch corrugated metal pipe (CMP) riser on the waterside (WS) slope. 6-foot by 12-foot concrete distribution box on the landside (LS). 7-foot by 14-foot concrete outlet structure on the WS toe. [Additional Reference(s): DWR Levee Log, 2002. USACE San Joaquin O&M Manual 601.1, 1967, (HLM 1.14)]. FS Date: 3/27/2014

Concrete box on WS toe.

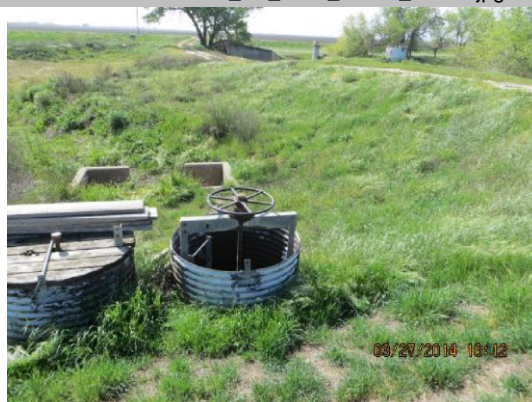
Photo 1 of 3 : UCIP_FA_2019_39524_59390.jpg

Comment Code						
Inspector Comment						
DS_ID:19908 FS_ID:39524 EP_NO: N/A Repair Type: Non-Urgent Crossing Status: Found UCIP Comments: 03/27/2014 No lid on riser at WS shoulder could be safety issue. (DWR UCIP - W. Wylie) FIELD_STRUCT_DESC: [Rounder Irrigation Structure] 2 of 2: 36-inch corrugated metal gravity drainage pipe through the levee, 12.3 feet below the crown. Slide gate in a 48-inch corrugated metal pipe (CMP) riser on the waterside (WS) slope. 6-foot by 12-foot concrete distribution box on the landside (LS). 7-foot by 14-foot concrete outlet structure on the WS toe. [Additional Reference(s): DWR Levee Log, 2002. USACE San Joaquin O&M Manual 601.1, 1967, (HLM 1.14)]. FS Date: 3/27/2014

Slide gate in CMP riser without at lid on WS shoulder.

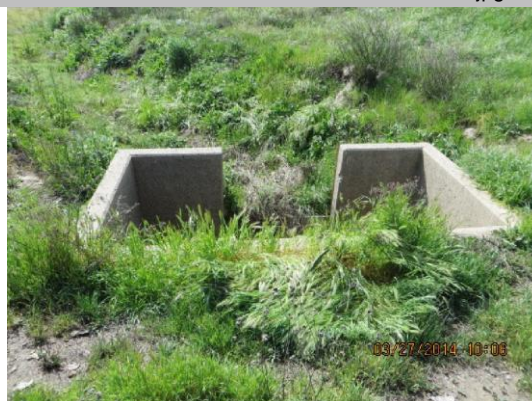
Photo 2 of 3 : UCIP_FA_2019_39524_59392.jpg

Concrete distribution box on WS toe.

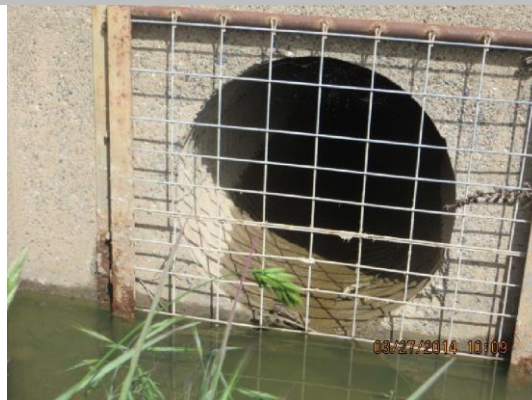
Photo 3 of 3 : UCIP_FA_2019_39524_59391.jpg

Pipe at outlet on WS toe.

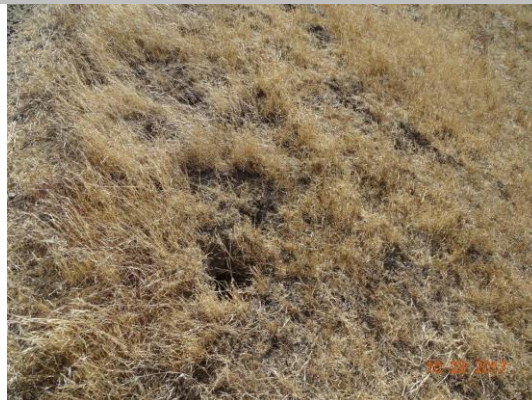
Photo 1 of 1 : FA_2019_NA0010_132_5_20190912_00002.jpg

LM Start	0.25	Rating **	M	Issue No.	5
LM End	0.25	Issue Type +	Ma	Location *	LS
Category	Earthen Levee			GPS Latitude/Longitude	
				Start	End
Item	Animal Control			37.035841 °	37.035841 °
				-120.439795 °	-120.439795 °
DWR ID	DWR_NA0010_14_f_2017_5				
Comment Code					
A3 : No rodents visible, but rodent burrows visible; need to backfill and compact or grout burrows.					
Inspector Comment

Looking at the landside slope.

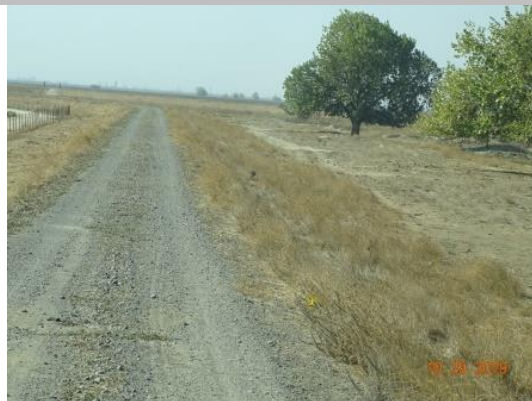
Photo 1 of 1 : FA_2019_NA0010_132_9_20191113_00010.jpg

LM Start	0.49	Rating **	U	Issue No.	9
LM End	0.75	Issue Type +	Ma	Location *	WS
Category	Earthen Levee			GPS Latitude/Longitude	
				Start	End
Item	Vegetation			37.039123°	37.042116°
				-120.438400°	-120.435634°
DWR ID	DWR_NA0010_14_f_2019_9				
Comment Code					
V1 : Control annual grass and weeds on the levee slopes and easements.					
Inspector Comment

Looking downstream along the waterside slope. (Fall 2019)

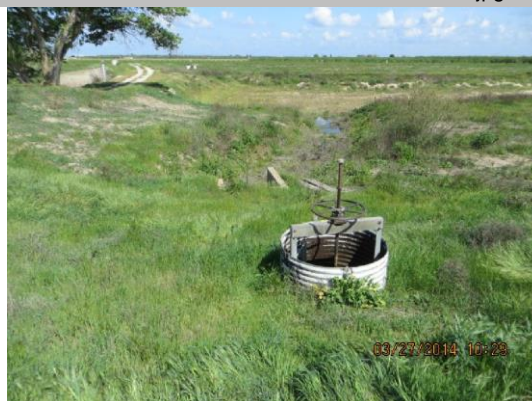
Photo 1 of 3 : UCIP_FA_2019_39526_59398.jpg

Comment Code						
Inspector Comment						
DS_ID:19909 FS_ID:39526 EP_NO: N/A Repair Type: Non-Urgent Crossing Status: Found UCIP Comments: 03/27/2014 Lid should be installed on CMP riser on WS slope, could be a safety hazard. Also dense vegetation limits the inspector's visibility to identify signs of pipe failure (leaks) along the slope. Recommend removing vegetation along pipe alignment to conduct proper inspection of structure. (DWR UCIP - O. Magana) FIELD_STRUCT_DESC: [Rounder Irrigation Structure] 36-inch corrugated metal gravity irrigation pipe through the levee, 10 feet below the crown. Slide gate in a 48-inch corrugated metal pipe (CMP) riser on the waterside (WS) slope. 6-foot by 7-foot concrete distribution box at the WS toe. Slots for wooden flashboards on the WS of the box. 7-foot by 9-foot concrete distribution box on the landside (LS), 20 feet from the toe. [Additional Reference(s): DWR Levee Log, 2002. USACE San Joaquin O&M Manual 601.1, 1967, (HLM 1.15)]. FS Date: 3/27/2014

Slide gate in CMP riser and outlet/inlet structure visible in background at WS toe.

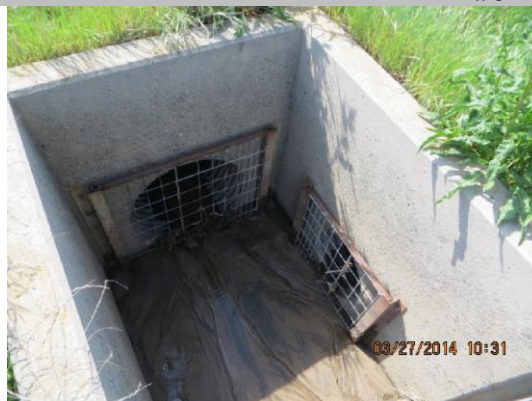
Photo 2 of 3 : UCIP_FA_2019_39526_59396.jpg

concrete inlet/outlet at WS toe.

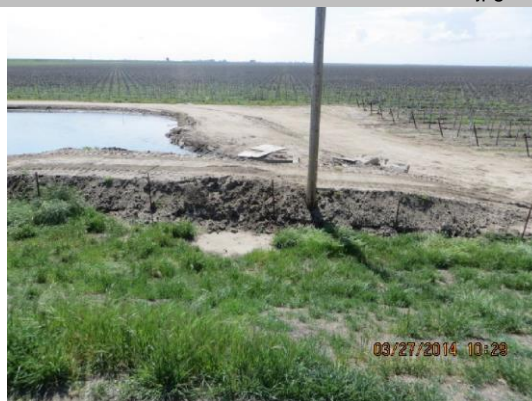
Photo 3 of 3 : UCIP_FA_2019_39526_59397.jpg

Comment Code						
Inspector Comment						
DS_ID:19909 FS_ID:39526 EP_NO: N/A Repair Type: Non-Urgent Crossing Status: Found UCIP Comments: 03/27/2014 Lid should be installed on CMP riser on WS slope, could be a safety hazard. Also dense vegetation limits the inspector's visibility to identify signs of pipe failure (leaks) along the slope. Recommend removing vegetation along pipe alignment to conduct proper inspection of structure. (DWR UCIP - O. Magana) FIELD_STRUCT_DESC: [Rounder Irrigation Structure] 36-inch corrugated metal gravity irrigation pipe through the levee, 10 feet below the crown. Slide gate in a 48-inch corrugated metal pipe (CMP) riser on the waterside (WS) slope. 6-foot by 7-foot concrete distribution box at the WS toe. Slots for wooden flashboards on the WS of the box. 7-foot by 9-foot concrete distribution box on the landside (LS), 20 feet from the toe. [Additional Reference(s): DWR Levee Log, 2002. USACE San Joaquin O&M Manual 601.1, 1967, (HLM 1.15)]. FS Date: 3/27/2014

Concrete distribution box visible next to power pole off LS toe.

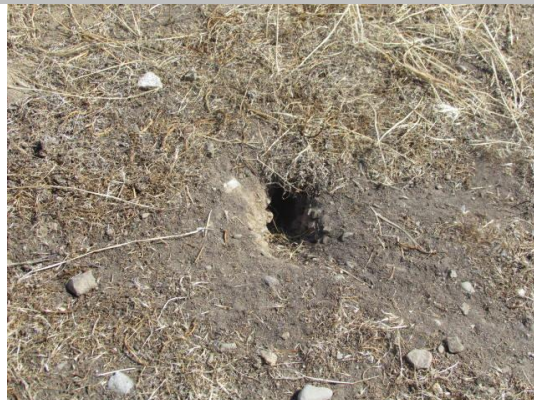
Photo 1 of 1 : FA_2019_NA0010_132_79_20190912_00003.jpg

LM Start	1.24	Rating **	M	Issue No.	79
LM End	1.24	Issue Type +	Ma	Location *	LS
Category	Earthen Levee			GPS Latitude/Longitude	
				Start	End
Item	Animal Control			37.045343 °	37.045343 °
				-120.428007 °	-120.428007 °
DWR ID	DWR_NA0010_14_s_2015_79				
Comment Code					
A3 : No rodents visible, but rodent burrows visible; need to backfill and compact or grout burrows.					
Inspector Comment					
Several rodent holes are noted on the landside at this location.

Looking at typical view of rodent holes on landward slope.

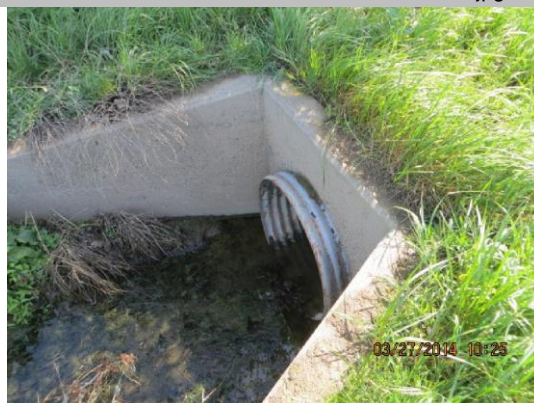
Photo 1 of 3 : UCIP_FA_2019_32828_59402.jpg

Concrete U-shaped headwall on Ws toe.

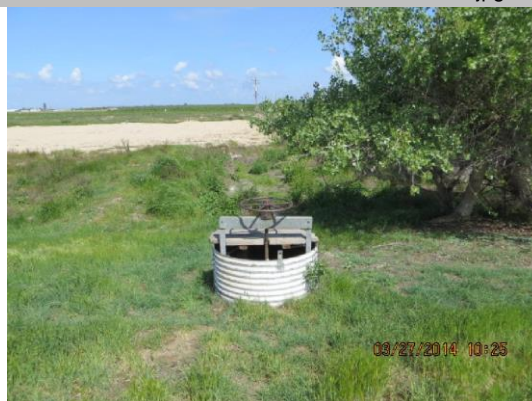
Photo 2 of 3 : UCIP_FA_2019_32828_59401.jpg

slidegate in CMP riser on WS slope.

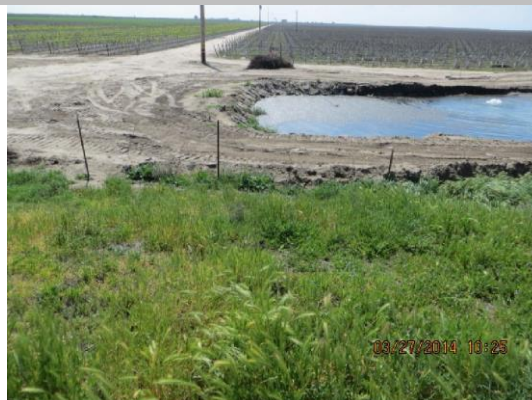
Photo 3 of 3 : UCIP_FA_2019_32828_59400.jpg

Inlet assumed to be within irrigation structure off LS toe.

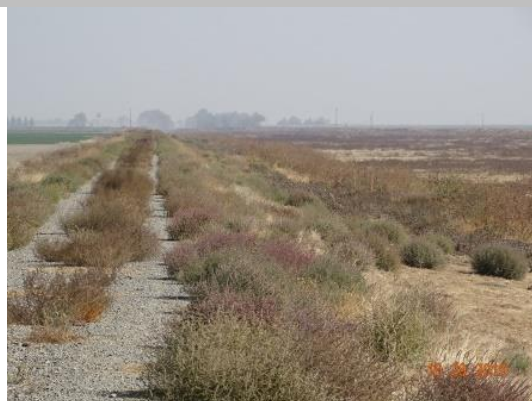
Photo 1 of 1 : FA_2019_NA0010_133_5_20191113_00012.jpg

LM Start	0.00	Rating **	U	Issue No.	5
LM End	1.52	Issue Type +	Ma	Location *	WS
Category	Earthen Levee			GPS Latitude/Longitude	
				Start	End
Item	Vegetation			36.996588 °	36.996563 °
				-120.410464 °	-120.382888 °
DWR ID	DWR_NA0010_15_f_2019_5				
Comment Code					
V1 : Control annual grass and weeds on the levee slopes and easements.					
Inspector Comment

View of the waterside slope looking upstream. (Fall 2019)

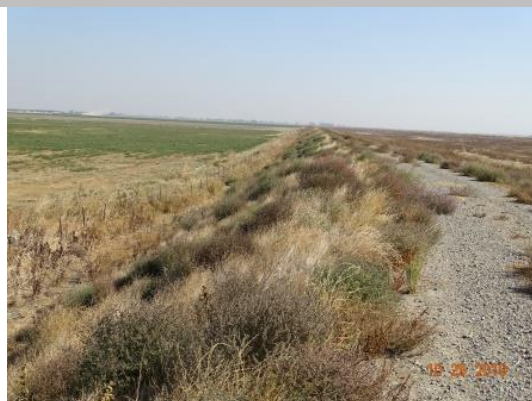
Photo 1 of 1 : FA_2019_NA0010_133_4_20191113_00013.jpg

LM Start	0.00	Rating **	U	Issue No.	4
LM End	2.01	Issue Type +	Ma	Location *	LS
Category	Earthen Levee			GPS Latitude/Longitude	
				Start	End
Item	Vegetation			36.996589 °	36.996586 °
				-120.410463 °	-120.374106 °
DWR ID	DWR_NA0010_15_f_2019_4				
Comment Code					
V1 : Control annual grass and weeds on the levee slopes and easements.					
Inspector Comment

View of the landside slope looking upstream. (Fall 2019)

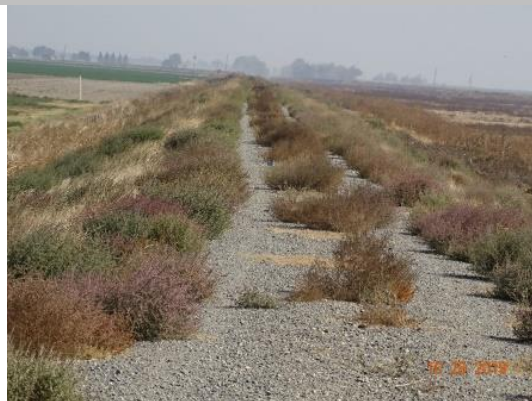
Photo 1 of 1 : FA_2019_NA0010_133_7_20191113_00014.jpg

LM Start	0.02	Rating **	U	Issue No.	7
LM End	1.51	Issue Type +	Ma	Location *	CR
Category	Earthen Levee			GPS Latitude/Longitude	
				Start	End
Item	Vegetation			36.996550 °	36.996552 °
				-120.410106 °	-120.383081 °
DWR ID	DWR_NA0010_15_f_2019_7				
Comment Code					
V9 : Keep the crown roadway free of vegetation.					
Inspector Comment

View along the levee crown looking upstream. (Fall 2019)

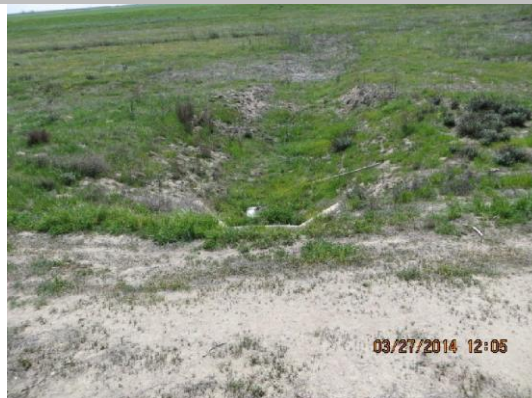
Photo 1 of 3 : UCIP_FA_2019_32838_59448.jpg

Concrete headwall on WS toe.

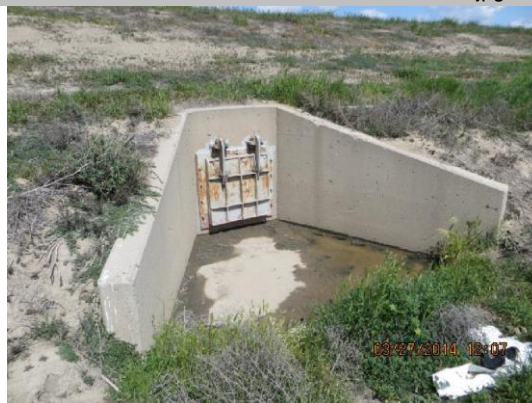
Photo 2 of 3 : UCIP_FA_2019_32838_59449.jpg

Flapgate on Concrete headwall at WS toe.

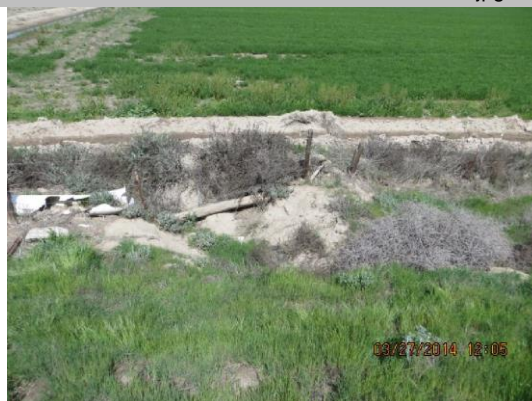
Photo 3 of 3 : UCIP_FA_2019_32838_59447.jpg

Concrete headwall on LS toe.

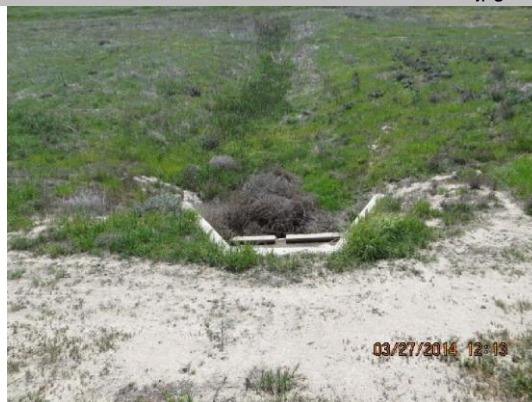
Photo 1 of 3 : UCIP_FA_2019_39527_59452.jpg

Comment Code					
Inspector Comment					
DS_ID:19912					
FS_ID:39527					
EP_NO: N/A					
Repair Type: Non-Urgent					
Crossing Status: Found					
UCIP Comments: 03/27/2014 Dense vegetation limits the inspector's visibility to identify signs of pipe failure (leaks) along the landward slope. Recommend removing vegetation along pipe alignment to conduct proper inspection of structure. (DWR UCIP - W. Wylie)					
FIELD_STRUCT_DESC: 30-inch by 30-inch square reinforced concrete box gravity drainage culvert through the levee, 8.5 feet below the crown. Flap gate on the waterside (WS) end. Concrete headwall on the landside (LS) end. Concrete U-shaped headwall on the WS end.					
[Additional Reference(s): DWR Levee Log, 2002. USACE San Joaquin O&M Manual 601.1, 1967, (HLM 1.01)].					
FS Date: 3/27/2014

Concrete headwall on WS toe.

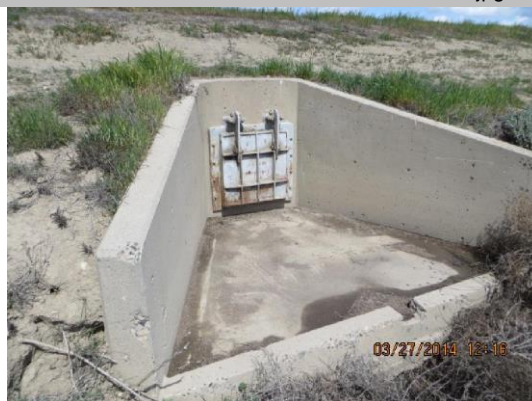
Photo 2 of 3 : UCIP_FA_2019_39527_59453.jpg

Flapgate on concrete headwall at WS toe.

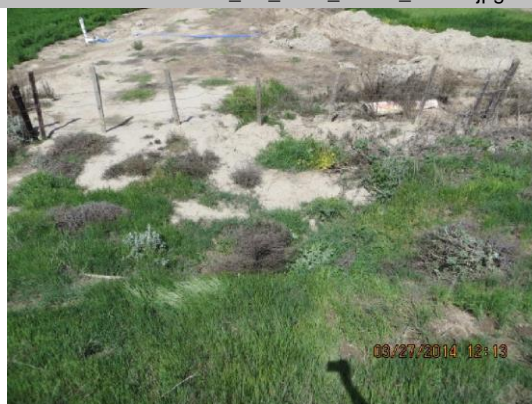
Photo 3 of 3 : UCIP_FA_2019_39527_59451.jpg

Concrete headwall on LS toe.

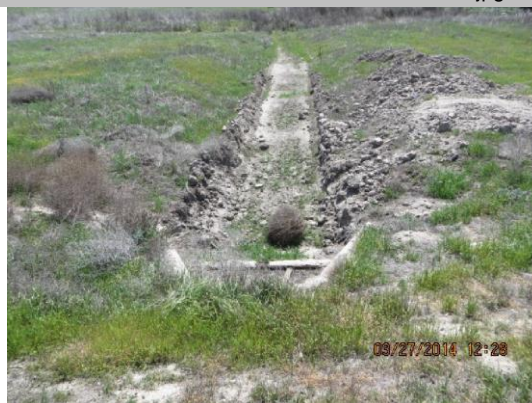
Photo 1 of 3 : UCIP_FA_2019_32840_59456.jpg

LM Start	1.53	Rating **	M	Issue No.	15	
LM End	1.53	Issue Type +	Ma	Location *		
Category	Supplemental			GPS Latitude/Longitude		
				Start		End
Item	DRAFT DWR UCIP LMA Responsibility			36.996582 °		36.996582 °
				-120.382757 °		-120.382757 °
DWR ID	19913					
Comment Code						
Inspector Comment						
DS_ID:19913 FS_ID:32840 EP_NO: N/A Repair Type: Non-Urgent Crossing Status: Found UCIP Comments: 03/27/2014 Excessive vegetation at inlet on LS toe. (DWR UCIP - W. Wylie) FIELD_STRUCT_DESC: 30-inch by 30-inch square reinforced concrete box gravity drainage culvert through the levee, 8.9 feet below the crown. Flap gate on the waterside (WS) end. Concrete headwall on the landside (LS) end. Concrete U-shaped headwall on the WS end. [Additional Reference(s): DWR Levee Log, 2002. USACE San Joaquin O&M Manual 601.1, 1967, (HLM 1.53)]. FS Date: 3/27/2014

Concrete headwall on WS toe.

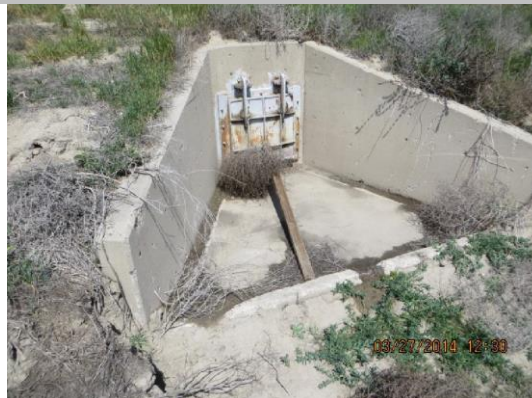
Photo 2 of 3 : UCIP_FA_2019_32840_59457.jpg

Flapgate on concrete headwall at WS toe.

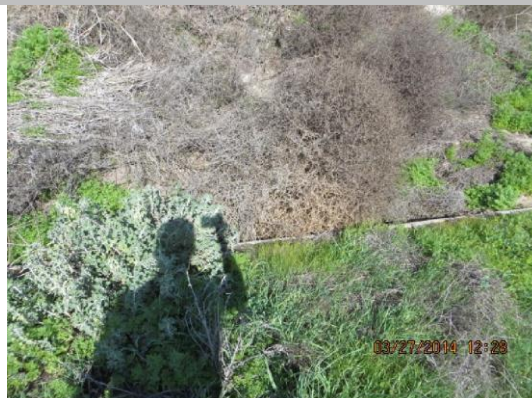
Photo 3 of 3 : UCIP_FA_2019_32840_59455.jpg

Concrete headwall on LS toe. Note excessive vegetation buildup.

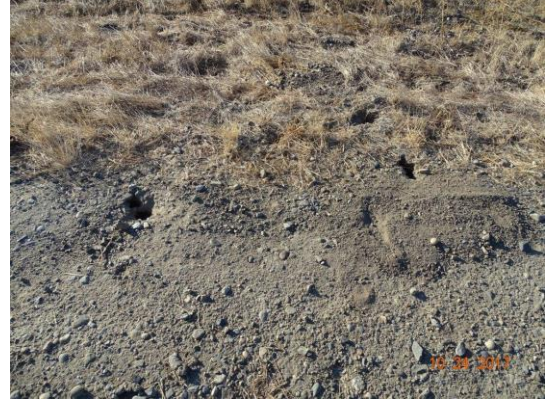
Photo 1 of 1 : FA_2019_NA0010_133_6_20190912_00001.jpg

LM Start	1.58	Rating **	M	Issue No.	6
LM End	2.01	Issue Type +	Ma	Location *	CR
Category	Earthen Levee			GPS Latitude/Longitude	
				Start	End
Item	Animal Control			36.996563 °	36.996578 °
				-120.381895 °	-120.374111 °
DWR ID	DWR_NA0010_15_f _ 2017_6				
Comment Code					
A3 : No rodents visible, but rodent burrows visible; need to backfill and compact or grout burrows.					
Inspector Comment

Representative picture of the crown.

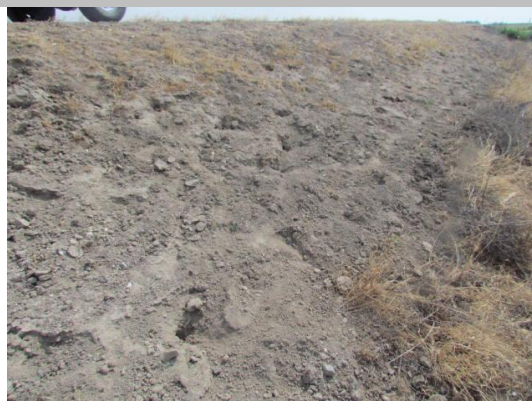
Photo 1 of 1 : FA_2019_NA0010_134_92_20190912_00007.jpg

LM Start	0.93	Rating **	M	Issue No.	92
LM End	0.93	Issue Type +	Ma	Location *	LS
Category	Earthen Levee			GPS Latitude/Longitude	
				Start	End
Item	Animal Control			36.995439 °	36.995439 °
				-120.392146 °	-120.392146 °
DWR ID	DWR_NA0010_16_s_2015_92				
Comment Code					
A3 : No rodents visible, but rodent burrows visible; need to backfill and compact or grout burrows.					
Inspector Comment					
Several rodent holes are identified within this section.

Looking at several rodent holes on landward slope.
