**Flood Control Project Maintenance
Levee Inspections**

Fall 2019 Levee Maintenance Deficiency Summary Report

San Joaquin River Basin

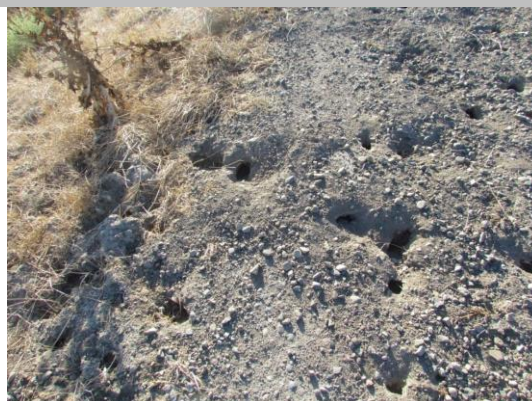
Photo 1 of 1 : FA_2019_NA0010_134_3_20190912_00003.jpg

LM Start	1.09	Rating **	M	Issue No.	3
LM End	1.09	Issue Type +	Ma	Location *	CR
Category	Earthen Levee			GPS Latitude/Longitude	
				Start	End
Item	Animal Control			36.995433 °	36.995433 °
				-120.389190 °	-120.389190 °
DWR ID	DWR_NA0010_16_f_2016_3				
Comment Code					
A3 : No rodents visible, but rodent burrows visible; need to backfill and compact or grout burrows.					
Inspector Comment					
Several rodent holes are identified on the levee crown.

Looking at several rodent holes and mole holes on levee crown.

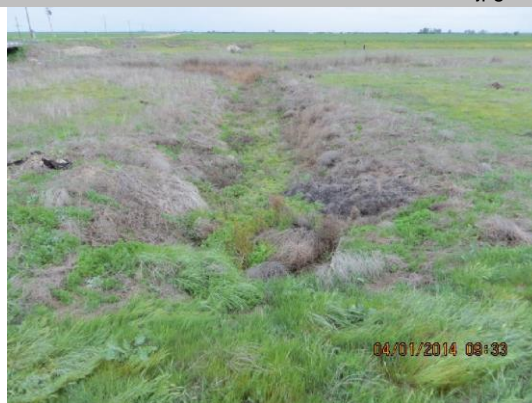
Photo 1 of 3 : UCIP_FA_2019_39529_59681.jpg

Comment Code						
Inspector Comment						
DS_ID:19915						
FS_ID:39529						
EP_NO: N/A						
Repair Type: Non-Urgent						
Crossing Status: Found						
UCIP Comments: 04/01/2014 Dense vegetation buildup at landside toe--recommend clearing. (DWR UCIP - W. Wylie)						
FIELD_STRUCT_DESC: 30-inch by 30-inch square reinforced concrete box gravity drainage culvert through the levee, 8.5 feet below the crown. Two concrete cutoff walls. Flap gate on the waterside (WS) end. Concrete headwall on the landside (LS) end. Concrete U-shaped headwall on the WS end. [Additional Reference(s): DWR Levee Log, 2002. USACE San Joaquin O&M Manual 601.1, 1967, (HLM 1.46)].						
FS Date: 4/1/2014 8:12:00 AM

Concrete headwall on WS toe with channel.

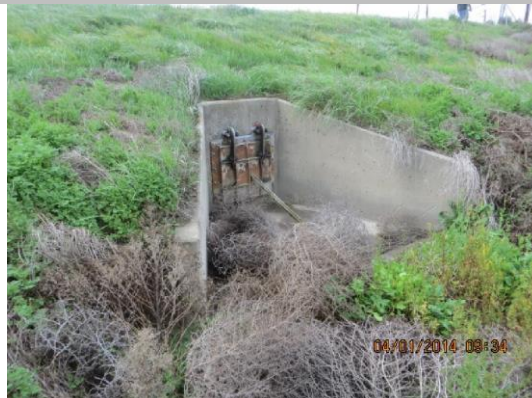
Photo 2 of 3 : UCIP_FA_2019_39529_59680.jpg

Flapgate on headwall at WS toe.

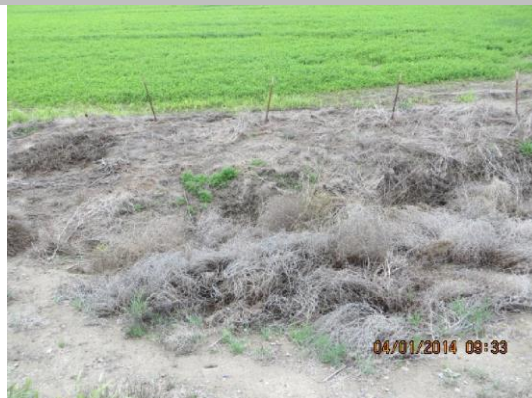
Photo 3 of 3 : UCIP_FA_2019_39529_59682.jpg

Concrete headwall on LS toe covered in vegetation/tumble weeds.

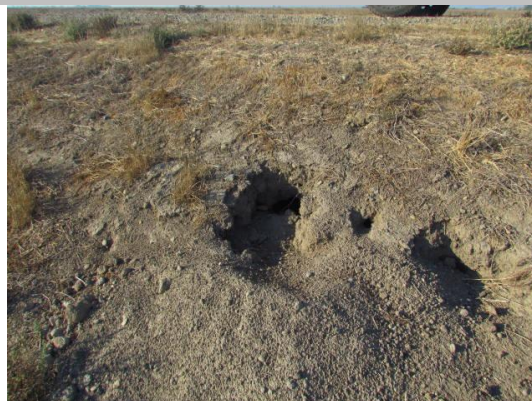
Photo 1 of 2 : FA_2019_NA0010_134_2_20190912_00001.jpg

LM Start	1.77	Rating **	U	Issue No.	2
LM End	1.77	Issue Type +	Ma	Location *	LS
Category	Earthen Levee			GPS Latitude/Longitude	
				Start	End
Item	Animal Control			36.995487 °	36.995487 °
				-120.377054 °	-120.377054 °
DWR ID	DWR_NA0010_16_f_2014_2				
Comment Code					
A3 : No rodents visible, but rodent burrows visible; need to backfill and compact or grout burrows.					
Inspector Comment					
Large rodent holes are on the landside slope.

Looking at large rodent holes on landward slope.

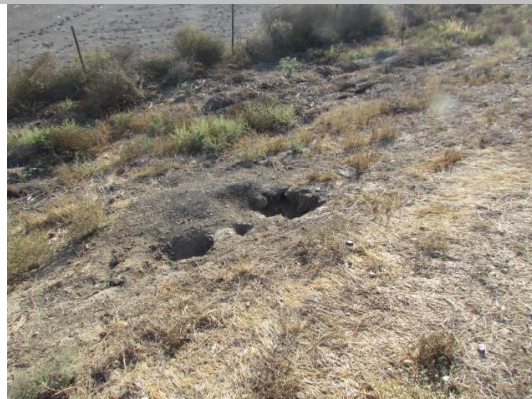
Photo 2 of 2 : FA_2019_NA0010_134_2_20190912_00002.jpg

Looking southwest at several rodent holes on landward slope.

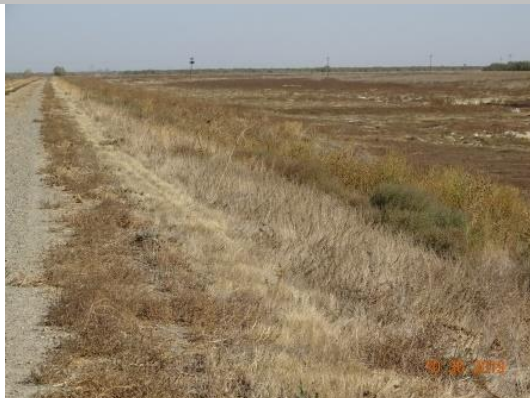
Photo 1 of 1 : FA_2019_NA0010_135_12_20191113_00036.jpg

LM Start	0.00	Rating **	U	Issue No.	12
LM End	4.28	Issue Type +	Ma	Location *	WS
Category	Earthen Levee			GPS Latitude/Longitude	
				Start	End
Item	Vegetation			36.976433 °	36.928947 °
				-120.374756 °	-120.338577 °
DWR ID	DWR_NA0010_17_f_2019_12				
Comment Code					
V1 : Control annual grass and weeds on the levee slopes and easements.					
Inspector Comment

View of the waterside slope looking upstream. (Fall 2019)

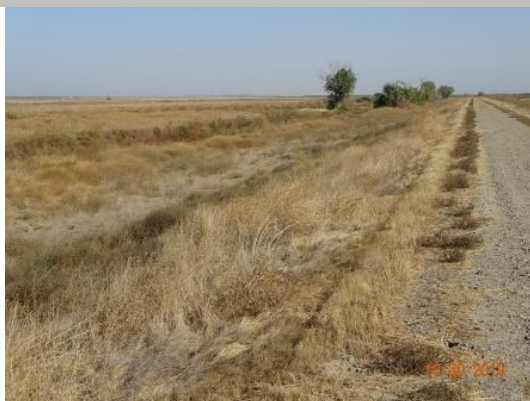
Photo 1 of 1 : FA_2019_NA0010_135_13_20191113_00037.jpg

LM Start	0.00	Rating **	U	Issue No.	13
LM End	4.29	Issue Type +	Ma	Location *	LS
Category	Earthen Levee			GPS Latitude/Longitude	
				Start	End
Item	Vegetation			36.976433 °	36.928855 °
				-120.374756 °	-120.338542 °
DWR ID	DWR_NA0010_17_f_2019_13				
Comment Code					
V1 : Control annual grass and weeds on the levee slopes and easements.					
Inspector Comment

Looking upstream along the landside slope. (Fall 2019)

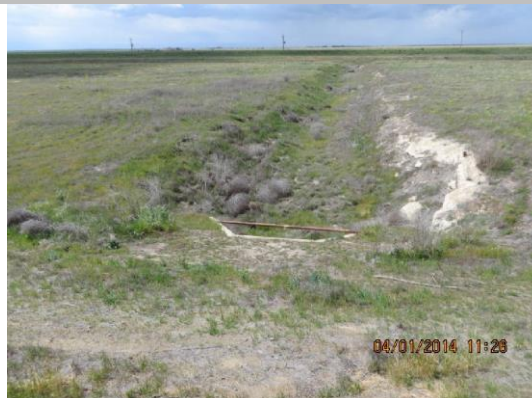
Photo 1 of 3 : UCIP_FA_2019_39531_59710.jpg

Comment Code						
Inspector Comment						
DS_ID:19916 FS_ID:39531 EP_NO: N/A Repair Type: Non-Urgent Crossing Status: Found UCIP Comments: 04/01/2014 Dense vegetation limits the inspector's visibility to identify signs of pipe failure (leaks) along the landward slope. Recommend removing vegetation along pipe alignment to conduct proper inspection of structure. (DWR UCIP - W. Wylie) FIELD_STRUCT_DESC: 48-inch by 60-inch reinforced concrete box gravity drainage culvert through the levee, 14.6 feet below the crown. Flap gate on the waterside (WS) end. Concrete headwall on the landside (LS) end. Concrete U-shaped headwall on the WS end. [Additional Reference(s): DWR Levee Log, 2002. USACE San Joaquin O&M Manual 601.1, 1967, (HLM 2.58)]. FS Date: 4/1/2014

Concrete headwall at channel on WS toe.

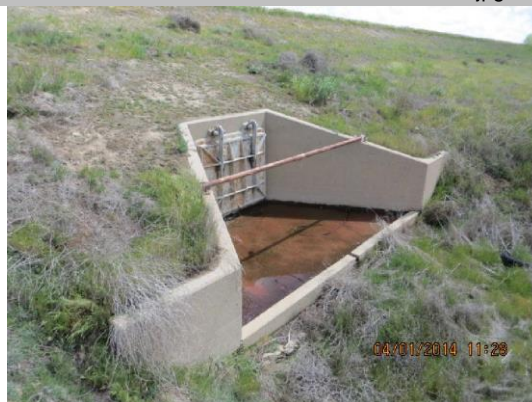
Photo 2 of 3 : UCIP_FA_2019_39531_59711.jpg

Flapgate on Concrete headwall at WS toe.

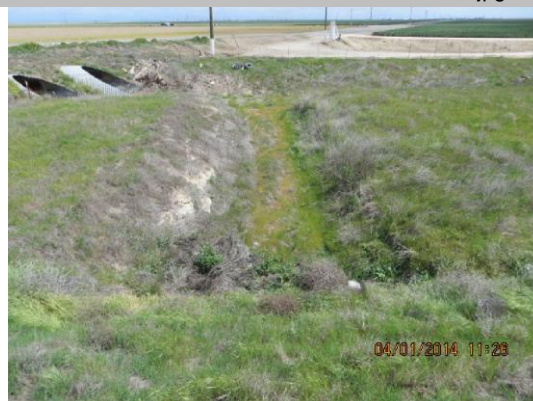
Photo 3 of 3 : UCIP_FA_2019_39531_59709.jpg

Comment Code						
Inspector Comment						
DS_ID:19916						
FS_ID:39531						
EP_NO: N/A						
Repair Type: Non-Urgent						
Crossing Status: Found						
UCIP Comments: 04/01/2014 Dense vegetation limits the inspector's visibility to identify signs of pipe failure (leaks) along the landward slope. Recommend removing vegetation along pipe alignment to conduct proper inspection of structure. (DWR UCIP - W. Wylie)						
FIELD_STRUCT_DESC: 48-inch by 60-inch reinforced concrete box gravity drainage culvert through the levee, 14.6 feet below the crown. Flap gate on the waterside (WS) end. Concrete headwall on the landside (LS) end. Concrete U-shaped headwall on the WS end. [Additional Reference(s): DWR Levee Log, 2002. USACE San Joaquin O&M Manual 601.1, 1967, (HLM 2.58)].						
FS Date: 4/1/2014

Concrete headwall at LS toe.

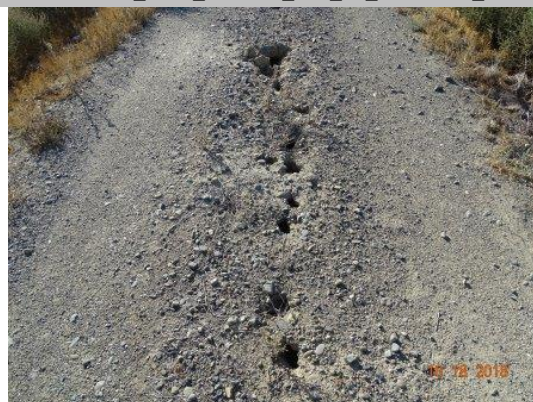
Photo 1 of 1 : FA_2019_NA0010_135_26_20190912_00010.jpg

LM Start	3.79	Rating **	M	Issue No.	26
LM End	3.79	Issue Type +	Ma	Location *	CR
Category	Earthen Levee			GPS Latitude/Longitude	
				Start	End
Item	Animal Control			36.935744 °	36.935744 °
				-120.341077 °	-120.341077 °
DWR ID	DWR_NA0010_17_f_2018_26				
Comment Code					
A3 : No rodents visible, but rodent burrows visible; need to backfill and compact or grout burrows.					
Inspector Comment

View of rodent holes along the center of the crown. (Fall 2018)

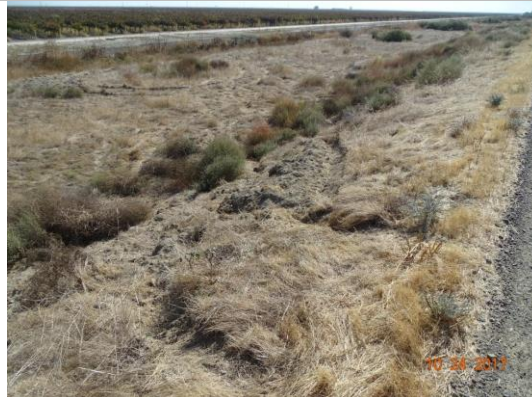
Photo 1 of 1 : FA_2019_NA0010_135_22_20190912_00007.jpg

LM Start	4.74	Rating **	M	Issue No.	22
LM End	4.74	Issue Type +	Ma	Location *	LS
Category	Earthen Levee		GPS Latitude/Longitude		
			Start	End	
Item	Slope Stability		36.922526 °	36.922526 °	
			-120.336227 °	-120.336227 °	
DWR ID	DWR_NA0010_17_f_2017_22				
Comment Code					
S3 : Repair the levee slope damaged by vehicle traffic and prevent access where possible.					
Inspector Comment

Looking southeast at the landside slope.

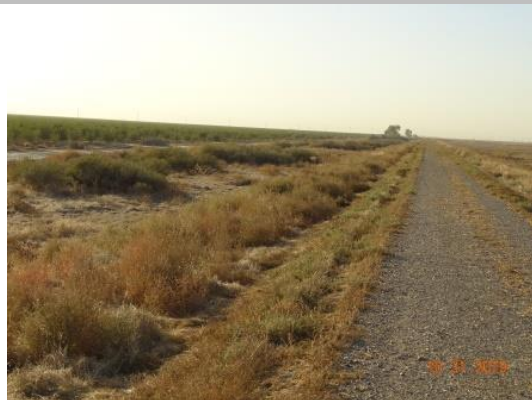
Photo 1 of 1 : FA_2019_NA0010_135_18_20191113_00038.jpg

LM Start	4.81	Rating **	U	Issue No.	18
LM End	9.37	Issue Type +	Ma	Location *	LS
Category	Earthen Levee			GPS Latitude/Longitude	
				Start	End
Item	Vegetation			36.921580 °	36.858091 °
				-120.335876 °	-120.314454 °
DWR ID	DWR_NA0010_17_f_2019_18				
Comment Code					
V1 : Control annual grass and weeds on the levee slopes and easements.					
Inspector Comment

View of the landside slope and toe looking upstream. (Fall 2019)

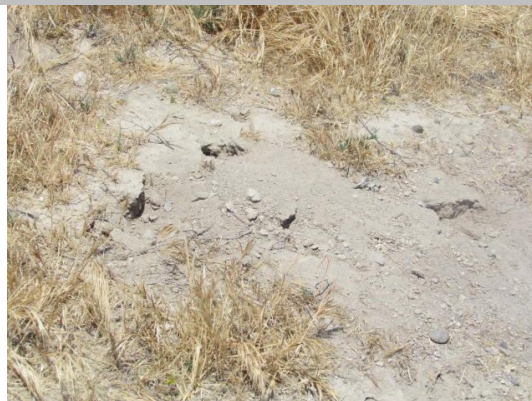
Photo 1 of 2 : FA_2019_NA0010_135_8_20190912_00005.jpg

LM Start	5.75	Rating **	M	Issue No.	8
LM End	5.90	Issue Type +	Ma	Location *	LS
Category	Earthen Levee			GPS Latitude/Longitude	
				Start	End
Item	Animal Control			36.908605 °	36.906507 °
				-120.331112 °	-120.330353 °
DWR ID	DWR_NA0010_17_s_2012_8				
Comment Code					
A1 : Exterminate rodents and backfill and compact or grout burrows.					
Inspector Comment					
Multiple rodent holes are noted on the landside slope.

Looking at several rodent holes on landward slope. (Spring 2015)

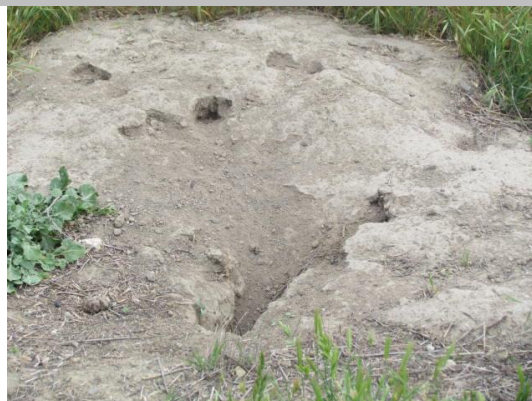
Photo 2 of 2 : FA_2019_NA0010_135_8_20190912_00006.jpg

Looking at several rodent holes on landside slope. (Fall 2014)

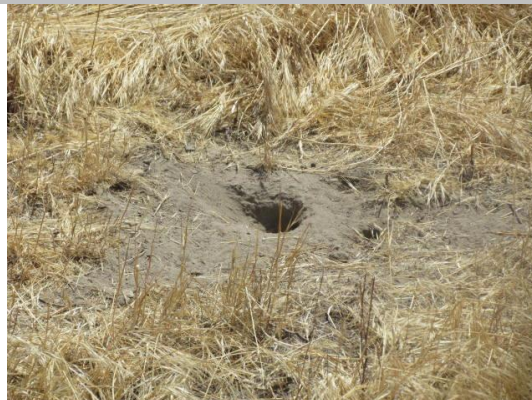
Photo 1 of 1 : FA_2019_NA0010_135_4_20190912_00003.jpg

LM Start	6.51	Rating **	M	Issue No.	4
LM End	6.72	Issue Type +	Ma	Location *	LS
Category	Earthen Levee			GPS Latitude/Longitude	
				Start	End
Item	Animal Control			36.898093 °	36.895300 °
				-120.326689 °	-120.325322 °
DWR ID	DWR_NA0010_17_s_2012_4				
Comment Code					
A1 : Exterminate rodents and backfill and compact or grout burrows.					
Inspector Comment					
Several rodent holes are identified within this reach.

Looking at typical view of rodent holes on landward slope.

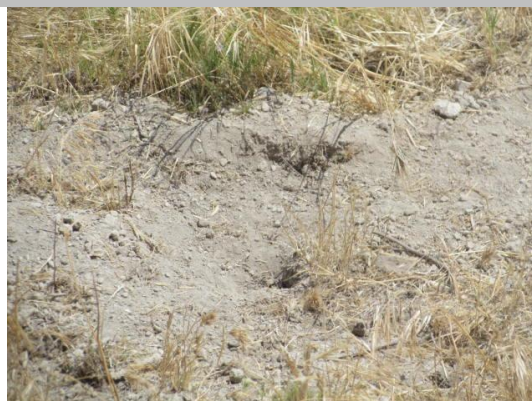
Photo 1 of 1 : FA_2019_NA0010_135_5_20190912_00004.jpg

LM Start	7.27	Rating **	M	Issue No.	5
LM End	7.38	Issue Type +	Ma	Location *	LS
Category	Earthen Levee			GPS Latitude/Longitude	
				Start	End
Item	Animal Control			36.887852 °	36.886388 °
				-120.321668 °	-120.320950 °
DWR ID	DWR_NA0010_17_s_2012_5				
Comment Code					
A3 : No rodents visible, but rodent burrows visible; need to backfill and compact or grout burrows.					
Inspector Comment					
Several rodent holes are identified within this reach.

Looking at typical view of rodent holes on landward slope.

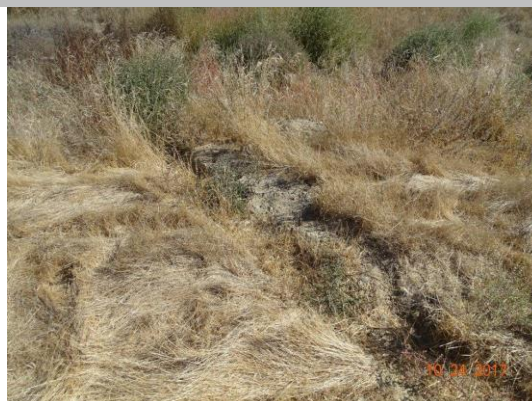
Photo 1 of 1 : FA_2019_NA0010_135_24_20190912_00009.jpg

LM Start	8.15	Rating **	M	Issue No.	24
LM End	8.15	Issue Type +	Ma	Location *	LS
Category	Earthen Levee			GPS Latitude/Longitude	
				Start	End
Item	Animal Control			36.875525 °	36.875525 °
				-120.317788 °	-120.317788 °
DWR ID	DWR_NA0010_17_f_2017_24				
Comment Code					
A3 : No rodents visible, but rodent burrows visible; need to backfill and compact or grout burrows.					
Inspector Comment					
Rodent holes are on the landside and crown of levee. Rodent holes have caused some erosion on the landside slope.

Looking east at the landside slope.

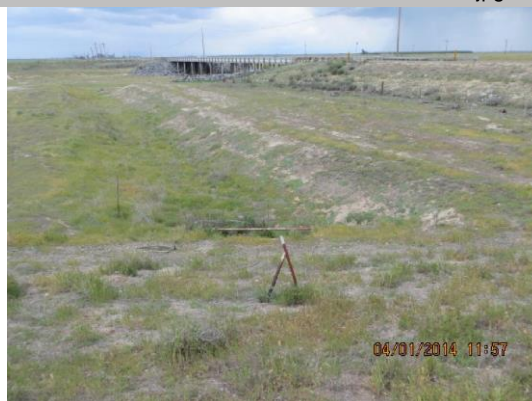
Photo 1 of 3 : UCIP_FA_2019_32999_59718.jpg

LM Start	8.37	Rating **	A/W	Issue No.	41
LM End	8.37	Issue Type +	Ma	Location *	
Category	Supplemental			GPS Latitude/Longitude	
				Start	End
Item	DRAFT DWR UCIP LMA Responsibility			36.872358 °	36.872358 °
				-120.317170 °	-120.317170 °
DWR ID	19922				
Comment Code					
Inspector Comment					
DS_ID:19922					
FS_ID:32999					
EP_NO: N/A					
Repair Type: No Action Needed					
Crossing Status: Found					
UCIP Comments:					
FIELD_STRUCT_DESC: 48-inch by 60-inch reinforced concrete box gravity drainage culvert through the levee, 16.5 feet below the crown. Flap gate on the waterside (WS) end. Concrete headwall on the landside (LS) end. Concrete U-shaped headwall on the WS end. [Additional Reference(s): DWR Levee Log, 2002. USACE San Joaquin O&M Manual 601.1, 1967, (HLM 8.38)].					
FS Date: 4/1/2014

Concrete headwall and channel on WS toe.

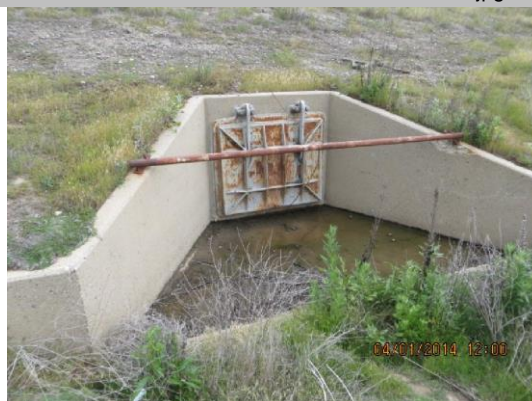
Photo 2 of 3 : UCIP_FA_2019_32999_59720.jpg

LM Start	8.37	Rating **	A/W	Issue No.	41 (cont)	
LM End	8.37	Issue Type +	Ma	Location *		
Category	Supplemental			GPS Latitude/Longitude		
				Start		End
Item	DRAFT DWR UCIP LMA Responsibility			36.872358 °		36.872358 °
				-120.317170 °		-120.317170 °
DWR ID	19922					
Comment Code						
Inspector Comment						
DS_ID:19922						
FS_ID:32999						
EP_NO: N/A						
Repair Type: No Action Needed						
Crossing Status: Found						
UCIP Comments:						
FIELD_STRUCT_DESC: 48-inch by 60-inch reinforced concrete box gravity drainage culvert through the levee, 16.5 feet below the crown. Flap gate on the waterside (WS) end. Concrete headwall on the landside (LS) end. Concrete U-shaped headwall on the WS end. [Additional Reference(s): DWR Levee Log, 2002. USACE San Joaquin O&M Manual 601.1, 1967, (HLM 8.38)].						
FS Date: 4/1/2014

Flapgate on concrete headwall at WS toe.

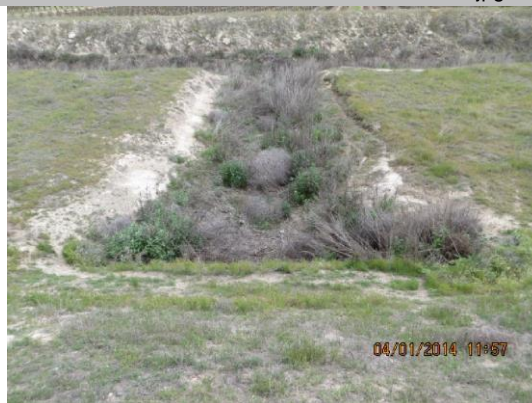
Photo 3 of 3 : UCIP_FA_2019_32999_59719.jpg

Concrete headwall and channel on LS toe.

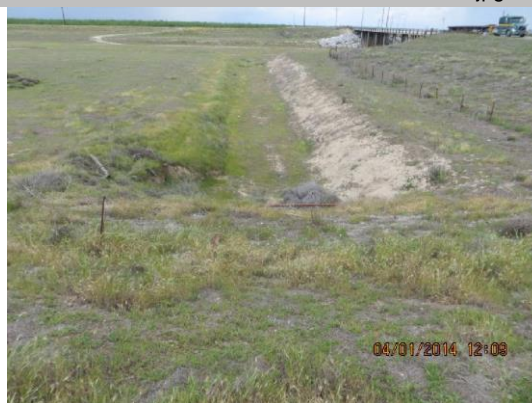
Photo 1 of 3 : UCIP_FA_2019_39532_59723.jpg

Comment Code					
Inspector Comment					
DS_ID:19917					
FS_ID:39532					
EP_NO: N/A					
Repair Type: Non-Urgent					
Crossing Status: Found					
UCIP Comments: 04/01/2014 Dense vegetation limits the inspector's visibility to identify signs of pipe failure (leaks) along the landward slope. Recommend removing vegetation along pipe alignment to conduct proper inspection of structure. (DWR UCIP - W. Wylie)					
FIELD_STRUCT_DESC: 48-inch by 60-inch reinforced concrete box gravity drainage culvert through the levee, 15 feet below the crown. Concrete headwall on the landside (LS) end. Concrete U-shaped headwall on the waterside (WS) end. [Additional Reference(s): DWR Levee Log, 2002. USACE San Joaquin O&M Manual 601.1, 1967, (HLM 9.89)].					
FS Date: 4/1/2014

Concrete headwall and channel on WS toe.

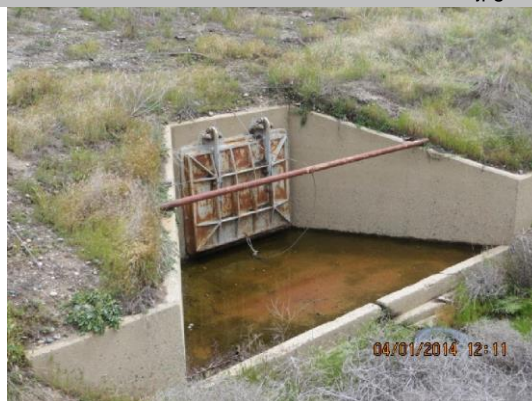
Photo 2 of 3 : UCIP_FA_2019_39532_59724.jpg

Comment Code						
Inspector Comment						
DS_ID:19917 FS_ID:39532 EP_NO: N/A Repair Type: Non-Urgent Crossing Status: Found UCIP Comments: 04/01/2014 Dense vegetation limits the inspector's visibility to identify signs of pipe failure (leaks) along the landward slope. Recommend removing vegetation along pipe alignment to conduct proper inspection of structure. (DWR UCIP - W. Wylie) FIELD_STRUCT_DESC: 48-inch by 60-inch reinforced concrete box gravity drainage culvert through the levee, 15 feet below the crown. Concrete headwall on the landside (LS) end. Concrete U-shaped headwall on the waterside (WS) end. [Additional Reference(s): DWR Levee Log, 2002. USACE San Joaquin O&M Manual 601.1, 1967, (HLM 9.89)]. FS Date: 4/1/2014

Flapgate on Concrete headwall at WS toe.

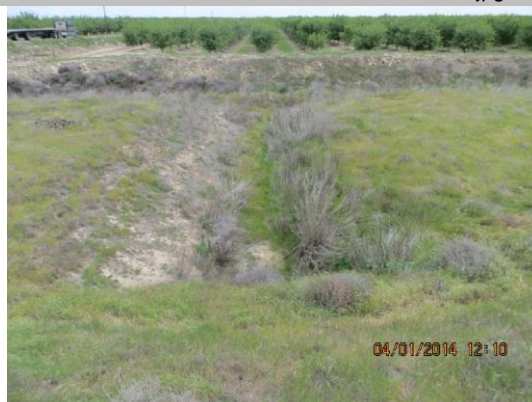
Photo 3 of 3 : UCIP_FA_2019_39532_59722.jpg

Concrete headwall and channel on LS toe.

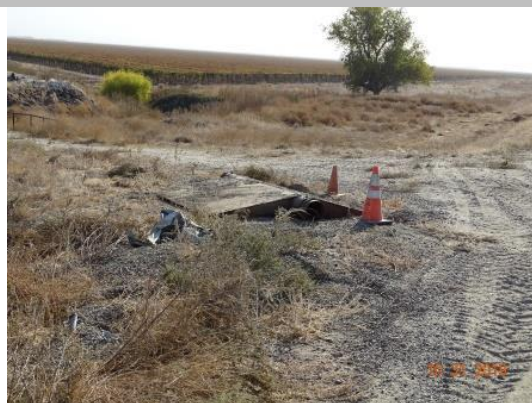
Photo 1 of 3 : FA_2019_NA0010_135_35_20191113_00039.jpg

LM Start	11.03	Rating **	M	Issue No.	35
LM End	11.03	Issue Type +	En	Location *	CR
Category	Earthen Levee			GPS Latitude/Longitude	
				Start	End
Item	Encroachments			36.836724 °	36.836724 °
				-120.305328 °	-120.305328 °
DWR ID	DWR_NA0010_17_f_2018_35				
Comment Code					
PI : Pipe					
Inspector Comment					
Temporary pipe and ramp were moved off the levee crown and are currently being stored on the waterside slope.

View of ramp and temporary pipe material left on the waterside slope. (Fall 2019)

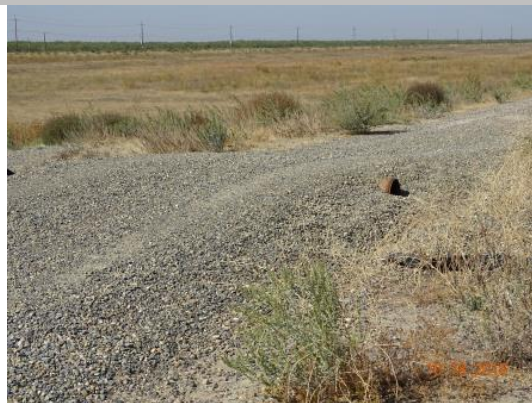
Photo 2 of 3 : FA_2019_NA0010_135_35_20190912_00011.jpg

View of pipe encroachment looking downstream. (Fall 2018)

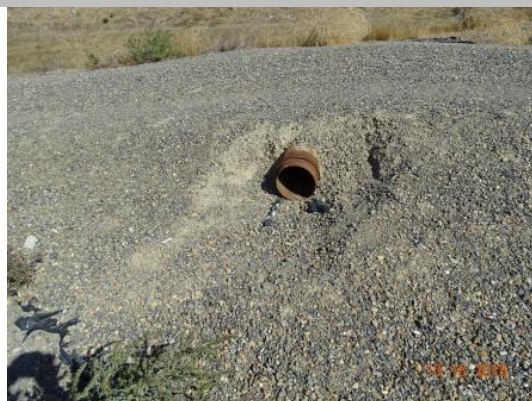
Photo 3 of 3 : FA_2019_NA0010_135_35_20190912_00012.jpg

LM Start	11.03	Rating **	M	Issue No.	35 (cont)	
LM End	11.03	Issue Type +	En	Location *	CR	
Category	Earthen Levee			GPS Latitude/Longitude		
				Start		End
Item	Encroachments			36.836724 °	36.836724 °	
				-120.305328 °	-120.305328 °	
DWR ID	DWR_NA0010_17_f_2018_35					
Comment Code						
PI : Pipe						
Inspector Comment						
Temporary pipe and ramp were moved off the levee crown and are currently being stored on the waterside slope.

View of pipe encroachment looking across crown. (Fall 2018)

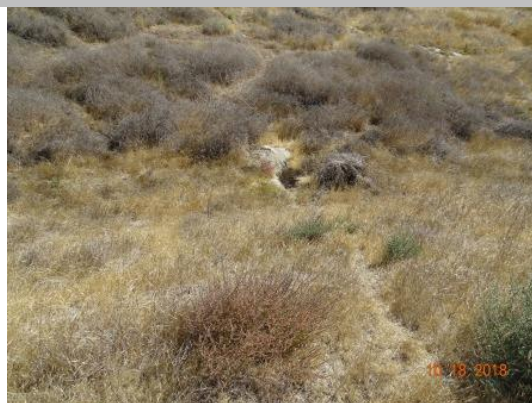
Photo 1 of 2 : FA_2019_NA0010_135_39_20190912_00013.jpg

LM Start	12.17	Rating **	U	Issue No.	39	
LM End	12.17	Issue Type +	Ma	Location *	LS	
Category	Earthen Levee			GPS Latitude/Longitude		
				Start		End
Item	Animal Control			36.822818 °		36.822818 °
				-120.299680 °		-120.299680 °
DWR ID	DWR_NA0010_17_f_2018_39					
Comment Code						
A3 : No rodents visible, but rodent burrows visible; need to backfill and compact or grout burrows.						
Inspector Comment						
A large hole is on the landside toe.

Large rodent hole at toe of levee. (Fall 2018)

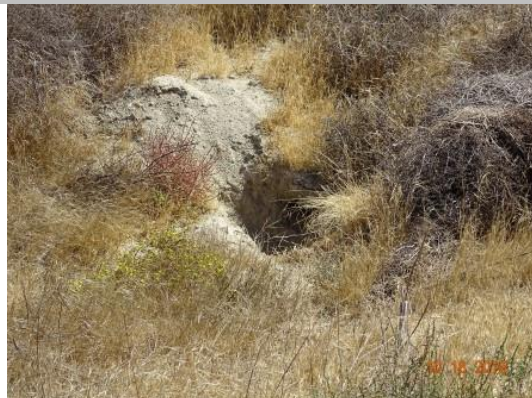
Photo 2 of 2 : FA_2019_NA0010_135_39_20190912_00014.jpg

LM Start	12.17	Rating **	U	Issue No.	39 (cont)	
LM End	12.17	Issue Type +	Ma	Location *	LS	
Category	Earthen Levee			GPS Latitude/Longitude		
				Start		End
Item	Animal Control			36.822818 °		36.822818 °
				-120.299680 °		-120.299680 °
DWR ID	DWR_NA0010_17_f_2018_39					
Comment Code						
A3 : No rodents visible, but rodent burrows visible; need to backfill and compact or grout burrows.						
Inspector Comment						
A large hole is on the landside toe.

Upclose view of rodent hole. (Fall 2018)

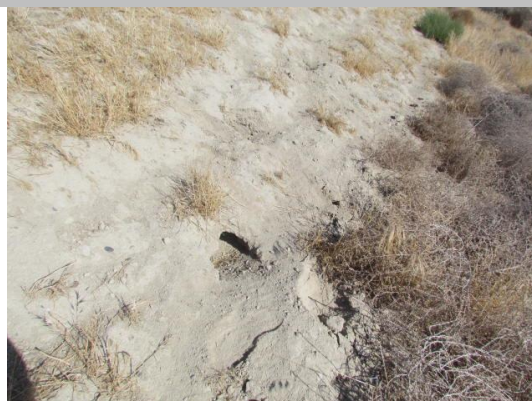
Photo 1 of 2 : FA_2019_NA0010_135_3_20190912_00001.jpg

LM Start	12.28	Rating **	M	Issue No.	3
LM End	12.38	Issue Type +	Ma	Location *	LS
Category	Earthen Levee			GPS Latitude/Longitude	
				Start	End
Item	Animal Control			36.821368 °	36.820000 °
				-120.300283 °	-120.300831 °
DWR ID	DWR_NA0010_17_s_2014_3				
Comment Code					
A3 : No rodents visible, but rodent burrows visible; need to backfill and compact or grout burrows.					
Inspector Comment					
Several rodent holes are identified within this reach.

Looking at typical view of rodent holes on landward slope. Fall 2015

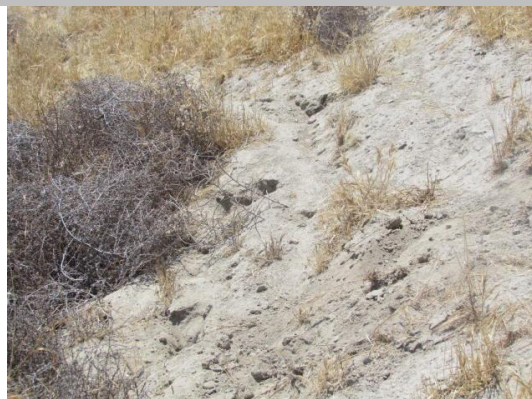
Photo 2 of 2 : FA_2019_NA0010_135_3_20190912_00002.jpg

Looking at several rodent holes on landward slope. Spring 2015

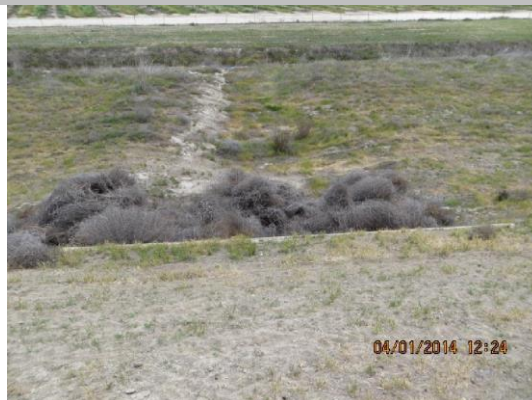
Photo 2 of 3 : UCIP_FA_2019_39533_59726.jpg

Comment Code						
Inspector Comment						
DS_ID:19918						
FS_ID:39533						
EP_NO: N/A						
Repair Type: Non-Urgent						
Crossing Status: Found						
UCIP Comments: 04/01/2014 Some vegetation buildup at inlet-recommend clearing. (DWR UCIP - W. Wylie)						
FIELD_STRUCT_DESC: 48-inch by 60-inch reinforced concrete box gravity drainage culvert through the levee, 15.3 feet below the crown.						
Flap gate on the waterside (WS) end. Concrete headwall on the landside (LS) end. Concrete U-shaped headwall on the WS end.						
[Additional Reference(s): DWR Levee Log, 2002. USACE San Joaquin O&M Manual 601.1, 1967, (HLM 13.30)].						
FS Date: 4/1/2014

Concrete headwall on LS toe.

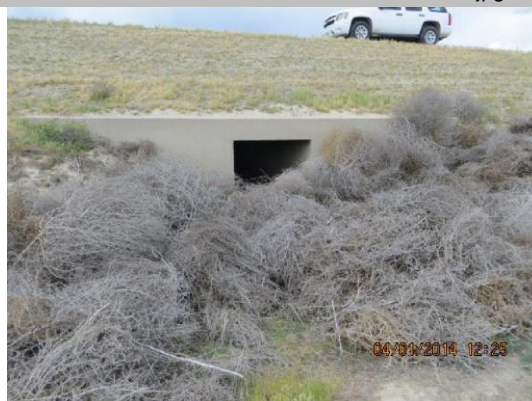
Photo 3 of 3 : UCIP_FA_2019_39533_59725.jpg

Comment Code						
Inspector Comment						
DS_ID:19918						
FS_ID:39533						
EP_NO: N/A						
Repair Type: Non-Urgent						
Crossing Status: Found						
UCIP Comments: 04/01/2014 Some vegetation buildup at inlet--recommend clearing. (DWR UCIP - W. Wylie)						
FIELD_STRUCT_DESC: 48-inch by 60-inch reinforced concrete box gravity drainage culvert through the levee, 15.3 feet below the crown.						
Flap gate on the waterside (WS) end. Concrete headwall on the landside (LS) end. Concrete U-shaped headwall on the WS end.						
[Additional Reference(s): DWR Levee Log, 2002. USACE San Joaquin O&M Manual 601.1, 1967, (HLM 13.30)].						
FS Date: 4/1/2014

Concrete headwall on LS toe. Some vegetation buildup.

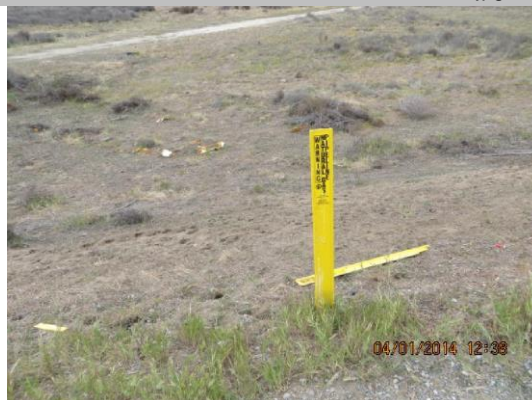
Photo 1 of 3 : UCIP_FA_2019_41406_71490.jpg

LM Start	14.38	Rating **	M	Issue No.	44
LM End	14.38	Issue Type +	En	Location *	
Category	Supplemental			GPS Latitude/Longitude	
				Start	End
Item	DRAFT DWR UCIP Field Study			36.793318 °	36.793318 °
				-120.302138 °	-120.302138 °
DWR ID	24850				
Comment Code					
Inspector Comment					
DS_ID:24850 FS_ID:41406 EP_NO: N/A Repair Type: Non-Urgent Crossing Status: Indicator Found UCIP Comments: 04/01/2014 No permit identified for this crossing. (DWR UCIP - W. Wylie) FIELD_STRUCT_DESC: Natural gas pipeline of an unknown size or material through the levee, at an unknown depth. Gas line markers on both shoulders. FS Date: 4/1/2014

Gasline marker on WS slope..

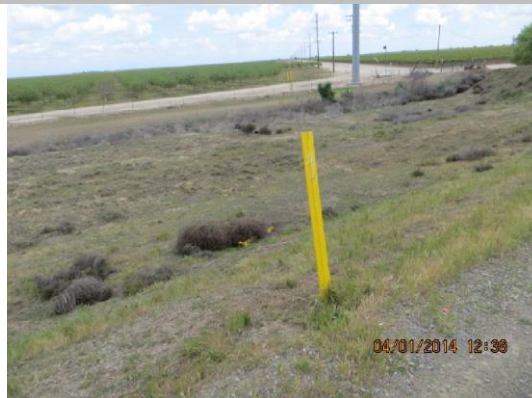
Photo 2 of 3 : UCIP_FA_2019_41406_71489.jpg

LM Start	14.38	Rating **	M	Issue No.	44 (cont)	
LM End	14.38	Issue Type +	En	Location *		
Category	Supplemental			GPS Latitude/Longitude		
				Start	End	
Item	DRAFT DWR UCIP Field Study			36.793318°	36.793318°	
				-120.302138°	-120.302138°	
DWR ID	24850					
Comment Code						
Inspector Comment						
DS_ID:24850						
FS_ID:41406						
EP_NO: N/A						
Repair Type: Non-Urgent						
Crossing Status: Indicator Found						
UCIP Comments: 04/01/2014 No permit identified for this crossing.						
(DWR UCIP - W. Wylie)						
FIELD_STRUCT_DESC: Natural gas pipeline of an unknown size or material through the levee, at an unknown depth. Gas line markers on both shoulders.						
FS Date: 4/1/2014

Gasline marker on LS shoulder.

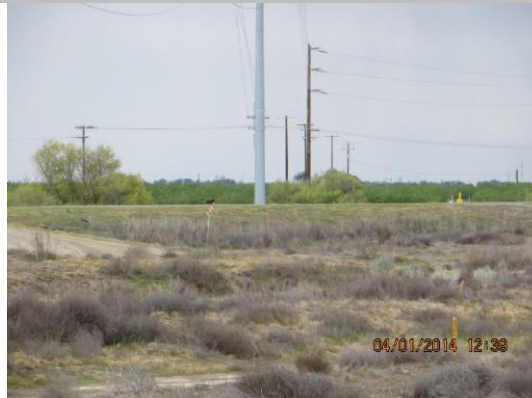
Photo 3 of 3 : UCIP_FA_2019_41406_71488.jpg

Gasline markers visible along right side of photo.

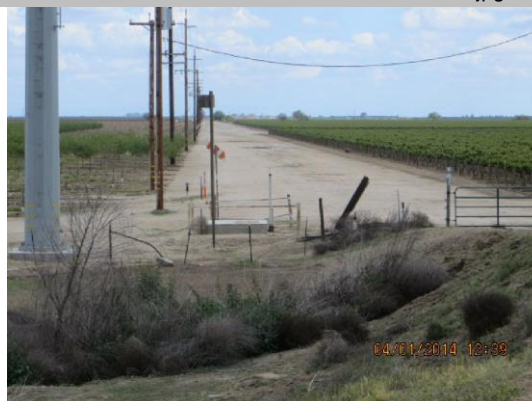
Photo 1 of 3 : UCIP_FA_2019_50067_59742.jpg

Comment Code						
Inspector Comment						
DS_ID:19562 FS_ID:50067 EP_NO: 18568 Repair Type: Non-Urgent Crossing Status: Indicator Found UCIP Comments: 7/20/2016 Marker visible on LS. WS marker missing. (DWR UCIP - omagana)4/01/2014 Need to contact owner to confirm and obtain status of crossing. Markers misleading--unable to confirm if markers correspond to this crossing. Need markers at levee. (DWR UCIP - wwylie) FIELD_STRUCT_DESC: 30-inch coated steel natural gas pipeline through the levee, approximately 60 feet below the crown. Gas line markers are visible on the waterside (WS) and the landside (LS). (30-inch horizontal directional bore (HDD) authorized under Permit No. 18568, 2010 - Gill Ranch Storage, LLC). FS Date: 7/20/2016

Gasline marker and concrete sump off LS toe.

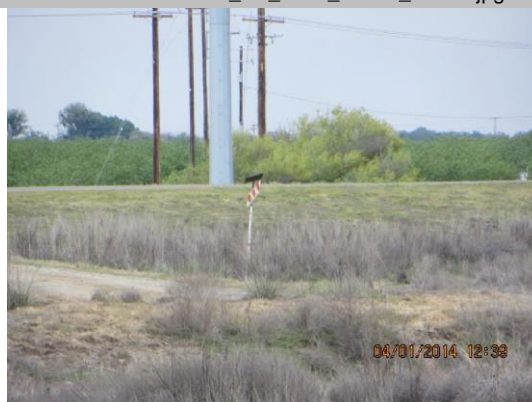
Photo 2 of 3 : UCIP_FA_2019_50067_59741.jpg

Gasline marker visible in channel off WS toe.

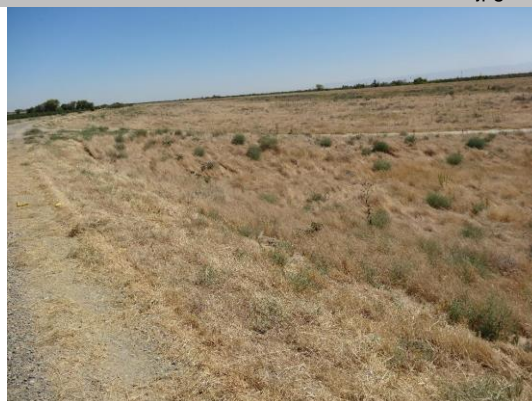
Photo 3 of 3 : UCIP_FA_2019_50067_75506.jpg

Comment Code						
Inspector Comment						
DS_ID:19562 FS_ID:50067 EP_NO: 18568 Repair Type: Non-Urgent Crossing Status: Indicator Found UCIP Comments: 7/20/2016 Marker visible on LS. WS marker missing. (DWR UCIP - omagana)4/01/2014 Need to contact owner to confirm and obtain status of crossing. Markers misleading--unable to confirm if markers correspond to this crossing. Need markers at levee. (DWR UCIP - wwyllie) FIELD_STRUCT_DESC: 30-inch coated steel natural gas pipeline through the levee, approximately 60 feet below the crown. Gas line markers are visible on the waterside (WS) and the landside (LS). (30-inch horizontal directional bore (HDD) authorized under Permit No. 18568, 2010 - Gill Ranch Storage, LLC). FS Date: 7/20/2016

View of WS.

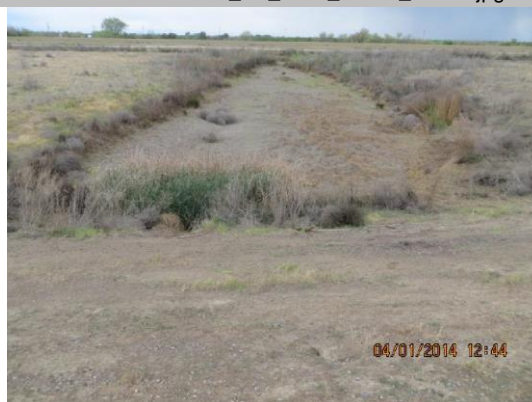
Photo 1 of 3 : UCIP_FA_2019_39535_59745.jpg

LM Start	14.69	Rating **	M	Issue No.	46
LM End	14.69	Issue Type +	Ma	Location *	
Category	Supplemental			GPS Latitude/Longitude	
				Start	End
Item	DRAFT DWR UCIP LMA Responsibility			36.789066 °	36.789066 °
				-120.300644 °	-120.300644 °
DWR ID	19920				
Comment Code					
Inspector Comment					
DS_ID:19920 FS_ID:39535 EP_NO: N/A Repair Type: Non-Urgent Crossing Status: Found UCIP Comments: 04/01/2014 Heavy vegetation buildup at LS toe--recommend clearing. (DWR UCIP - W. Wylie) FIELD_STRUCT_DESC: 30-inch by 30-inch square reinforced concrete box gravity drainage culvert through the levee, 14 feet below the crown. Flap gate on the waterside (WS) end. Concrete headwall on the landside (LS) end. Concrete U-shaped headwall on the WS end. [Additional Reference(s): DWR Levee Log, 2002. USACE San Joaquin O&M Manual 601.1, 1967, (HLM 14.69)]. FS Date: 4/1/2014

Concrete headwall at WS toe.

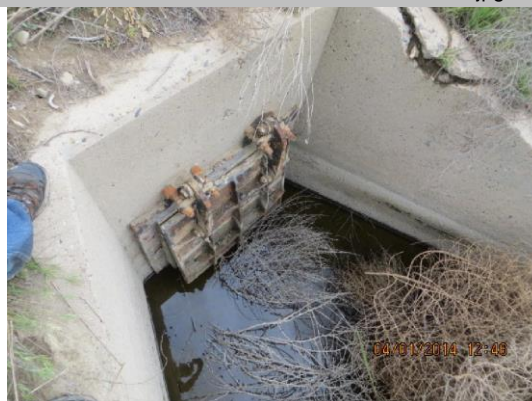
Photo 2 of 3 : UCIP_FA_2019_39535_59747.jpg

LM Start	14.69	Rating **	M	Issue No.	46 (cont)	
LM End	14.69	Issue Type +	Ma	Location *		
Category	Supplemental			GPS Latitude/Longitude		
				Start		End
Item	DRAFT DWR UCIP LMA Responsibility			36.789066 °		36.789066 °
				-120.300644 °		-120.300644 °
DWR ID	19920					
Comment Code						
Inspector Comment						
DS_ID:19920 FS_ID:39535 EP_NO: N/A Repair Type: Non-Urgent Crossing Status: Found UCIP Comments: 04/01/2014 Heavy vegetation buildup at LS toe-- recommend clearing. (DWR UCIP - W. Wylie) FIELD_STRUCT_DESC: 30-inch by 30-inch square reinforced concrete box gravity drainage culvert through the levee, 14 feet below the crown. Flap gate on the waterside (WS) end. Concrete headwall on the landside (LS) end. Concrete U-shaped headwall on the WS end. [Additional Reference(s): DWR Levee Log, 2002. USACE San Joaquin O&M Manual 601.1, 1967, (HLM 14.69)]. FS Date: 4/1/2014

Flapgate on Concrete headwall at WS toe.

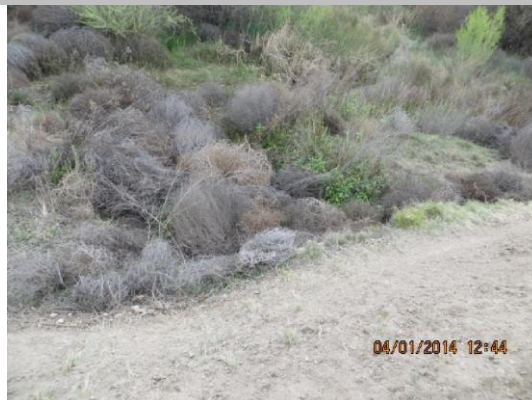
Photo 3 of 3 : UCIP_FA_2019_39535_59746.jpg

Concrete headwall at channel on LS toe. Heavy vegetation buildup.

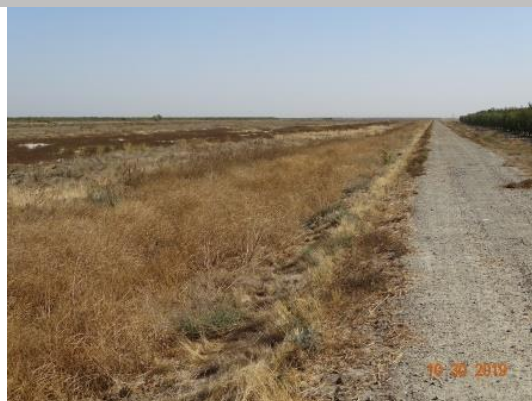
Photo 1 of 1 : FA_2019_NA0010_137_10_20191113_00022.jpg

LM Start	0.00	Rating **	U	Issue No.	10
LM End	0.49	Issue Type +	Ma	Location *	WS
Category	Earthen Levee			GPS Latitude/Longitude	
				Start	End
Item	Vegetation			36.974134 °	36.968932 °
				-120.363267 °	-120.357464 °
DWR ID	DWR_NA0010_18_f_2019_10				
Comment Code					
V1 : Control annual grass and weeds on the levee slopes and easements.					
Inspector Comment

Looking upstream along the waterside slope. (Fall 2019)

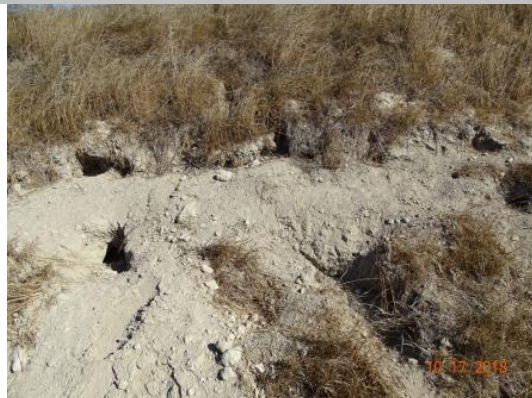
Photo 1 of 1 : FA_2019_NA0010_137_55_20190912_00009.jpg

LM Start	0.78	Rating **	M	Issue No.	55
LM End	0.78	Issue Type +	Ma	Location *	LS
Category	Earthen Levee			GPS Latitude/Longitude	
				Start	End
Item	Animal Control			36.964824 °	36.964824 °
				-120.358065 °	-120.358065 °
DWR ID	DWR_NA0010_18_f_2018_55				
Comment Code					
A3 : No rodents visible, but rodent burrows visible; need to backfill and compact or grout burrows.					
Inspector Comment

View of rodent holes from levee toe looking towards centerline. (Fall 2018)

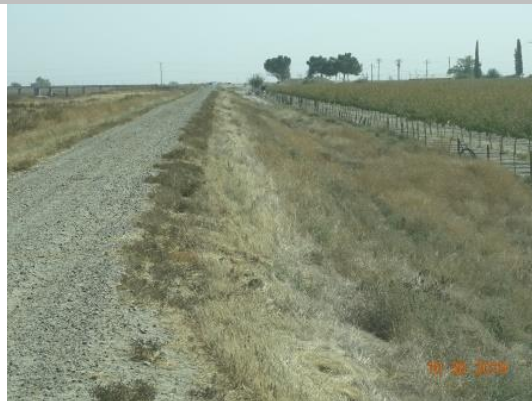
Photo 1 of 1 : FA_2019_NA0010_137_17_20191113_00023.jpg

LM Start	1.15	Rating **	U	Issue No.	17
LM End	1.34	Issue Type +	Ma	Location *	LS
Category	Earthen Levee			GPS Latitude/Longitude	
				Start	End
Item	Vegetation			36.959808 °	36.957441 °
				-120.355969 °	-120.354472 °
DWR ID	DWR_NA0010_18_f_2019_17				
Comment Code					
V1 : Control annual grass and weeds on the levee slopes and easements.					
Inspector Comment

View of the landside slope looking upstream. (Fall 2019)

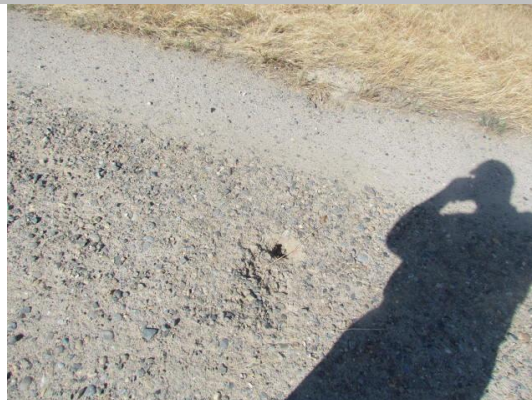
Photo 1 of 1 : FA_2019_NA0010_137_7_20190912_00002.jpg

LM Start	1.44	Rating **	M	Issue No.	7
LM End	1.44	Issue Type +	Ma	Location *	LS
Category	Earthen Levee			GPS Latitude/Longitude	
				Start	End
Item	Animal Control			36.956163 °	36.956163 °
				-120.353672 °	-120.353672 °
DWR ID	DWR_NA0010_18_f_2018_7				
Comment Code					
A3 : No rodents visible, but rodent burrows visible; need to backfill and compact or grout burrows.					
Inspector Comment					
There are several rodent holes identified on landside slope and on the levee crown.

Looking at typical view of rodent holes within this section on landward slope.

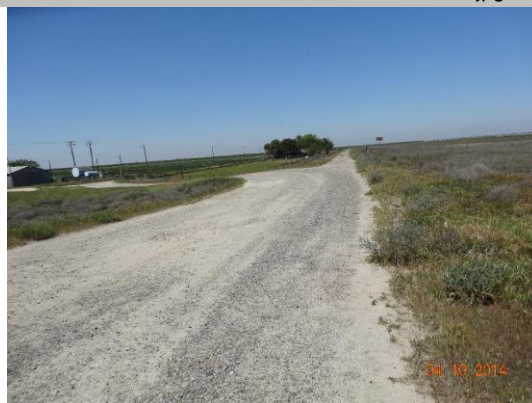
Photo 1 of 3 : UCIP_FA_2019_39503_66660.jpg

Comment Code						
Inspector Comment						
DS_ID:19925 FS_ID:39503 EP_NO: 6603 Repair Type: Non-Urgent Crossing Status: Found UCIP Comments: 04/10/2014 Need to contact owner. Appears abandoned--good candidate for video or pressure inspection. This crossings is the same age as the pipe that has failed immediately upstream. (DWR UCIP - O. Magana) FIELD_STRUCT_DESC: 15-inch steel irrigation discharge pipe through the levee, 4.3 feet below the crown. Electrical conduit of an unknown size or material through the levee, 4.3 feet below the crown. Siphon breaker on the landside (LS) shoulder. 36-inch concrete standpipe on the LS berm. Inlet facility on the waterside (WS) bank consisting of a pump, a 42-inch concrete standpipe, and a 20-inch concrete channel with an intake pipe and a cutoff wall. (Plans to install a pump and outlet pipe at two locations on the left bank levee of the Chowchilla Bypass authorized under Permit No. 6603, 1969 - Raymond N. Costales). [Additional Reference(s): DWR Levee Log, 2002]. FS Date: 4/10/2014

Overview of levee crown at crossing.

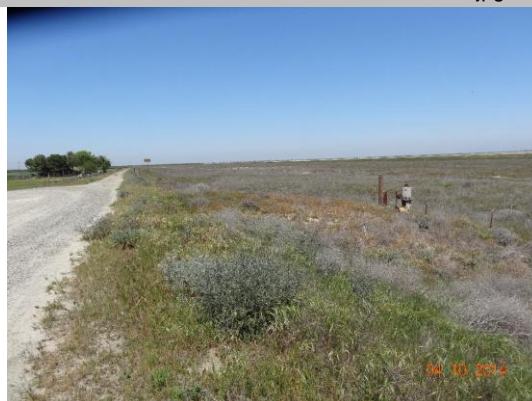
Photo 2 of 3 : UCIP_FA_2019_39503_66657.jpg

Comment Code						
Inspector Comment						
DS_ID:19925 FS_ID:39503 EP_NO: 6603 Repair Type: Non-Urgent Crossing Status: Found UCIP Comments: 04/10/2014 Need to contact owner. Appears abandoned--good candidate for video or pressure inspection. This crossings is the same age as the pipe that has failed immediately upstream. (DWR UCIP - O. Magana) FIELD_STRUCT_DESC: 15-inch steel irrigation discharge pipe through the levee, 4.3 feet below the crown. Electrical conduit of an unknown size or material through the levee, 4.3 feet below the crown. Siphon breaker on the landside (LS) shoulder. 36-inch concrete standpipe on the LS berm. Inlet facility on the waterside (WS) bank consisting of a pump, a 42-inch concrete standpipe, and a 20-inch concrete channel with an intake pipe and a cutoff wall. (Plans to install a pump and outlet pipe at two locations on the left bank levee of the Chowchilla Bypass authorized under Permit No. 6603, 1969 - Raymond N. Costales). [Additional Reference(s): DWR Levee Log, 2002]. FS Date: 4/10/2014

View of waterward side.

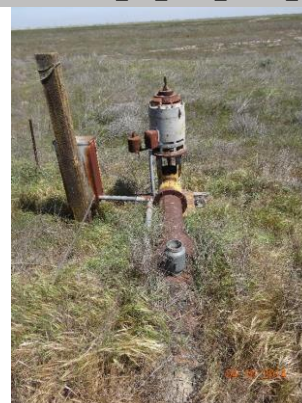
Photo 3 of 3 : UCIP_FA_2019_39503_66658.jpg

Pump system located on waterward slope.

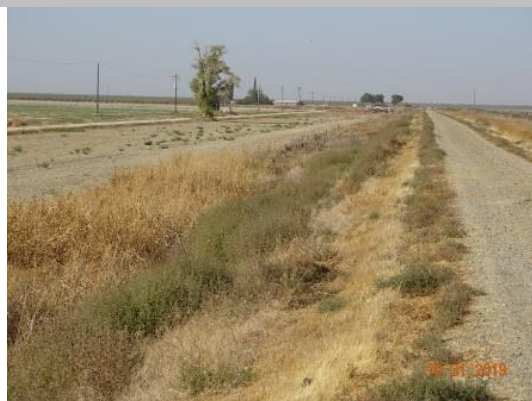
Photo 1 of 1 : FA_2019_NA0010_137_32_20191113_00024.jpg

LM Start	1.75	Rating **	U	Issue No.	32
LM End	2.18	Issue Type +	Ma	Location *	LS
Category	Earthen Levee			GPS Latitude/Longitude	
				Start	End
Item	Vegetation			36.952115 °	36.946441 °
				-120.351175 °	-120.347657 °
DWR ID	DWR_NA0010_18_f_2019_32				
Comment Code					
V1 : Control annual grass and weeds on the levee slopes and easements.					
Inspector Comment

View of the vegetation along the landside slope and toe. (Fall 2019)

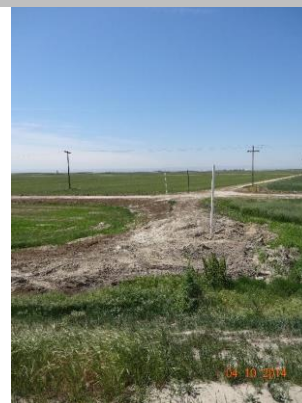
Photo 1 of 3 : UCIP_FA_2019_49968_60558.jpg

Comment Code					
Inspector Comment					
DS_ID:19926 FS_ID:49968 EP_NO: 6603 Repair Type: Non-Urgent Crossing Status: Found UCIP Comments: 7/20/2016 High burrow activity. Dense vegetation limits the inspector's visibility to identify signs of pipe failure (leaks) along the WS and LS slope. Recommend removing vegetation along pipe alignment to conduct proper inspection of structure and appurtenances. (DWR UCIP - omagana)4/10/2014 Subsidence present along pipe alignment on landward side. Modified crossing--worked done on landward side. Need to contact owner to determine permit authorizing work. Dense vegetation on landward side--tall grass. Pipe wall cut and new pipe sleeved on landward side. (DWR UCIP - omagana) FIELD_STRUCT_DESC: 15-inch steel irrigation discharge pipe and electrical conduit through the levee, 3.7 feet below the crown. Siphon breaker on the landside (LS) shoulder. 36-inch concrete standpipe on the LS berm. Inlet facility on the riverbank, consisting of a pump, a 42-inch concrete standpipe, and a 20-inch concrete channel with an intake pipe and a cutoff wall. (Plans to install a pump and outlet pipe at two locations on the left bank levee of the Chowchilla Bypass authorized under Permit No. 6603, 1969 - Raymond N. Costales). [Additional Reference(s): DWR Levee Log, 2002]. FS Date: 7/20/2016

Overview of LS--site modified.

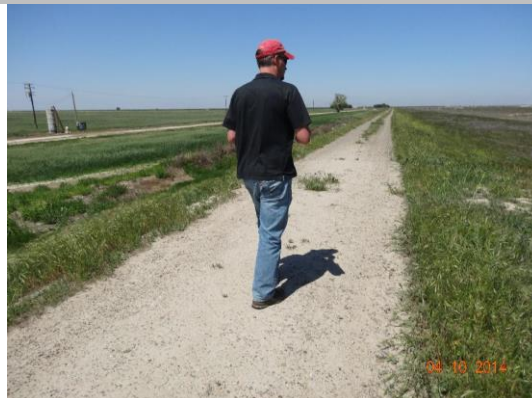
Photo 2 of 3 : UCIP_FA_2019_49968_60559.jpg

Comment Code						
Inspector Comment						
DS_ID:19926 FS_ID:49968 EP_NO: 6603 Repair Type: Non-Urgent Crossing Status: Found UCIP Comments: 7/20/2016 High burrow activity. Dense vegetation limits the inspector's visibility to identify signs of pipe failure (leaks) along the WS and LS slope. Recommend removing vegetation along pipe alignment to conduct proper inspection of structure and appurtenances. (DWR UCIP - omagana)4/10/2014 Subsidence present along pipe alignment on landward side. Modified crossing--worked done on landward side. Need to contact owner to determine permit authorizing work. Dense vegetation on landward side--tall grass. Pipe wall cut and new pipe sleeved on landward side. (DWR UCIP - omagana) FIELD_STRUCT_DESC: 15-inch steel irrigation discharge pipe and electrical conduit through the levee, 3.7 feet below the crown. Siphon breaker on the landside (LS) shoulder. 36-inch concrete standpipe on the LS berm. Inlet facility on the riverbank, consisting of a pump, a 42-inch concrete standpipe, and a 20-inch concrete channel with an intake pipe and a cutoff wall. (Plans to install a pump and outlet pipe at two locations on the left bank levee of the Chowchilla Bypass authorized under Permit No. 6603, 1969 - Raymond N. Costales). [Additional Reference(s): DWR Levee Log, 2002]. FS Date: 7/20/2016

View of levee crown at crossing.

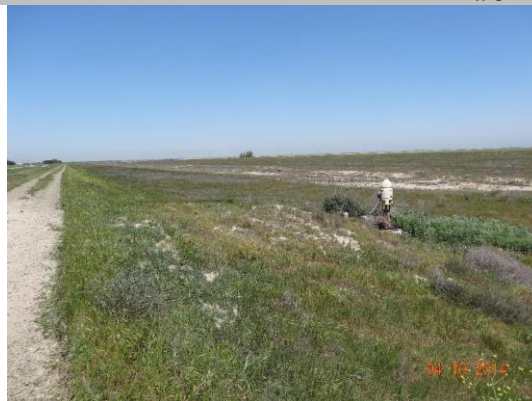
Photo 3 of 3 : UCIP_FA_2019_49968_60560.jpg

View of WS.

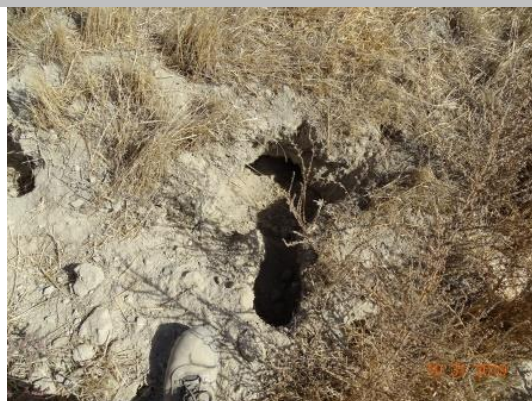
Photo 2 of 2 : FA_2019_NA0010_137_31_20191113_00026.jpg

LM Start	3.44	Rating **	U	Issue No.	31 (cont)	
LM End	3.44	Issue Type +	Ma	Location *	LS	
Category	Earthen Levee			GPS Latitude/Longitude		
				Start		End
Item	Animal Control			36.929093 °		36.929093 °
				-120.340920 °		-120.340920 °
DWR ID	DWR_NA0010_18_f_2019_31					
Comment Code						
A3 : No rodents visible, but rodent burrows visible; need to backfill and compact or grout burrows.						
Inspector Comment

Representative view of rodent hole. (Fall 2019)

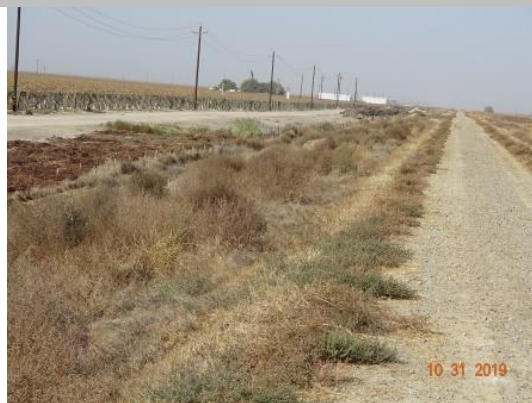
Photo 1 of 1 : FA_2019_NA0010_137_26_20191113_00034.jpg

LM Start	3.57	Rating **	U	Issue No.	26
LM End	5.28	Issue Type +	Ma	Location *	LS
Category	Earthen Levee			GPS Latitude/Longitude	
				Start	End
Item	Vegetation			36.927285 °	36.903486 °
				-120.340257 °	-120.331570 °
DWR ID	DWR_NA0010_18_f_2019_26				
Comment Code					
V1 : Control annual grass and weeds on the levee slopes and easements.					
Inspector Comment

View of the landside slope looking downstream. (Fall 2019)

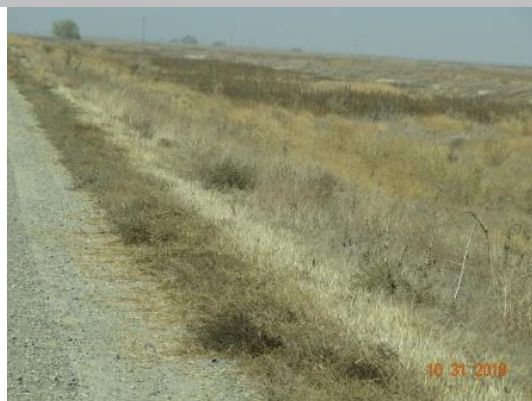
Photo 1 of 1 : FA_2019_NA0010_137_28_20191113_00033.jpg

LM Start	3.68	Rating **	U	Issue No.	28
LM End	5.13	Issue Type +	Ma	Location *	WS
Category	Earthen Levee			GPS Latitude/Longitude	
				Start	End
Item	Vegetation			36.925790 °	36.905609 °
				-120.339710 °	-120.332343 °
DWR ID	DWR_NA0010_18_f_2019_28				
Comment Code					
V1 : Control annual grass and weeds on the levee slopes and easements.					
Inspector Comment

View of the waterside slope looking downstream. (Fall 2019)

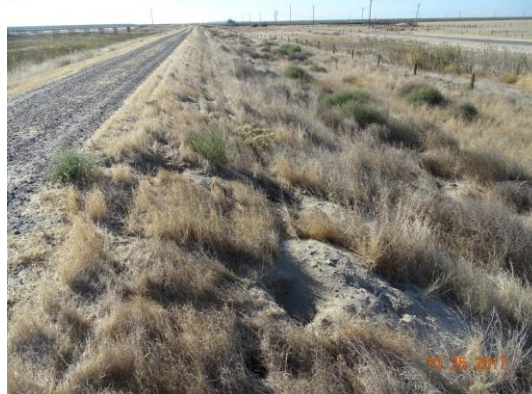
Photo 1 of 1 : FA_2019_NA0010_137_14_20190912_00006.jpg

LM Start	7.39	Rating **	U	Issue No.	14
LM End	7.53	Issue Type +	Ma	Location *	LS
Category	Earthen Levee			GPS Latitude/Longitude	
				Start	End
Item	Animal Control			36.874479 °	36.872503 °
				-120.319831 °	-120.319438 °
DWR ID	DWR_NA0010_18_f_2017_14				
Comment Code					
A3 : No rodents visible, but rodent burrows visible; need to backfill and compact or grout burrows.					
Inspector Comment					
There are several rodent holes noted along the landside slope in this area.

Looking south at the landside slope.

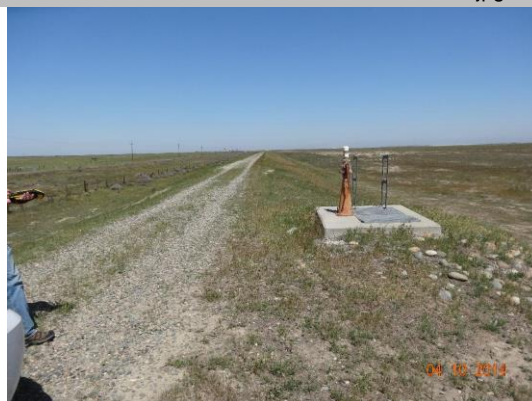
Photo 1 of 3 : UCIP_FA_2019_36843_67202.jpg

Comment Code						
Inspector Comment						
DS_ID:19930 FS_ID:36843 EP_NO: N/A Repair Type: Non-Urgent Crossing Status: Found UCIP Comments: 04/10/2014 CMP crossing is distorted on waterward side. Debris scattered on landward side. Sediment deposit inside crossing visible from landward side. Recommend removing debris from landward side. (DWR UCIP - O. Magana) FIELD_STRUCT_DESC: 42-inch reinforced concrete gravity irrigation pipe through the levee, 19 feet below the crown. Gate structure on the waterside (WS) shoulder. Pipe section on the WS is corrugated metal. Pipe section on the landside (LS) is reinforced concrete. (Plans to install a 42-inch gravity-flow concrete pipeline through the left bank levee of the Eastside Bypass to divert bypass waters for irrigation purposes authorized under Permit No. 13548, 1983 - New Stone Water District). [Additional Reference(s): DWR Levee Log, 2002]. FS Date: 4/10/2014

Overview of levee crown at crossing--slide gate inside concrete box located on waterward shoulder.

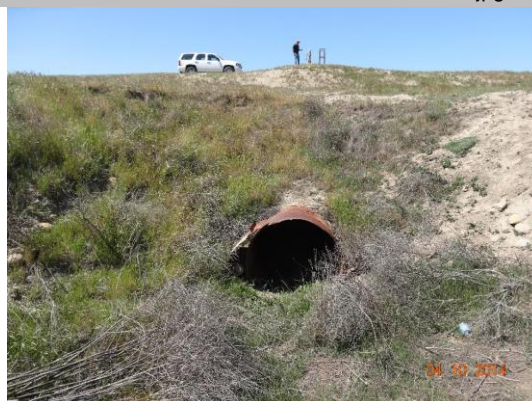
Photo 2 of 3 : UCIP_FA_2019_36843_67205.jpg

Comment Code						
Inspector Comment						
DS_ID:19930 FS_ID:36843 EP_NO: N/A Repair Type: Non-Urgent Crossing Status: Found UCIP Comments: 04/10/2014 CMP crossing is distorted on waterward side. Debris scattered on landward side. Sediment deposit inside crossing visible from landward side. Recommend removing debris from landward side. (DWR UCIP - O. Magana) FIELD_STRUCT_DESC: 42-inch reinforced concrete gravity irrigation pipe through the levee, 19 feet below the crown. Gate structure on the waterside (WS) shoulder. Pipe section on the WS is corrugated metal. Pipe section on the landside (LS) is reinforced concrete. (Plans to install a 42-inch gravity-flow concrete pipeline through the left bank levee of the Eastside Bypass to divert bypass waters for irrigation purposes authorized under Permit No. 13548, 1983 - New Stone Water District). [Additional Reference(s): DWR Levee Log, 2002]. FS Date: 4/10/2014

Pipe section distorted on waterward side.
