**Flood Control Project Maintenance
Levee Inspections**

Fall 2019 Levee Maintenance Deficiency Summary Report

San Joaquin River Basin

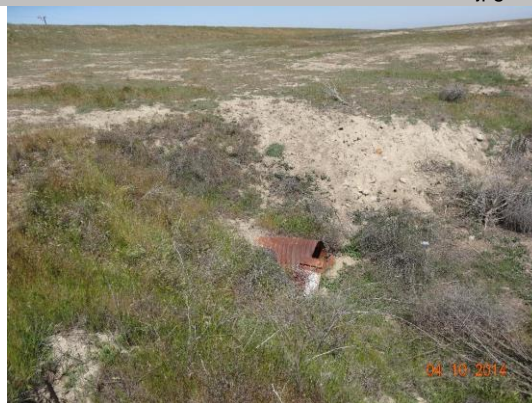
Photo 3 of 3 : UCIP_FA_2019_36843_67200.jpg

Comment Code						
Inspector Comment						
DS_ID:19930 FS_ID:36843 EP_NO: N/A Repair Type: Non-Urgent Crossing Status: Found UCIP Comments: 04/10/2014 CMP crossing is distorted on waterward side. Debris scattered on landward side. Sediment deposit inside crossing visible from landward side. Recommend removing debris from landward side. (DWR UCIP - O. Magana) FIELD_STRUCT_DESC: 42-inch reinforced concrete gravity irrigation pipe through the levee, 19 feet below the crown. Gate structure on the waterside (WS) shoulder. Pipe section on the WS is corrugated metal. Pipe section on the landside (LS) is reinforced concrete. (Plans to install a 42-inch gravity-flow concrete pipeline through the left bank levee of the Eastside Bypass to divert bypass waters for irrigation purposes authorized under Permit No. 13548, 1983 - New Stone Water District). [Additional Reference(s): DWR Levee Log, 2002]. FS Date: 4/10/2014

CMP section visible on waterward side.

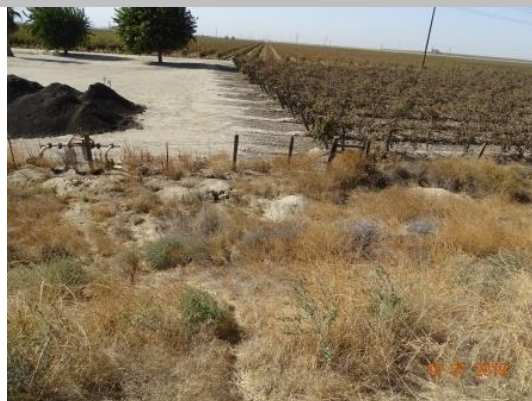
Photo 1 of 1 : FA_2019_NA0010_137_21_20191113_00031.jpg

LM Start	7.91	Rating **	U	Issue No.	21
LM End	7.91	Issue Type +	Ma	Location *	LS
Category	Earthen Levee			GPS Latitude/Longitude	
				Start	End
Item	Animal Control			36.867030 °	36.867030 °
				-120.318361 °	-120.318361 °
DWR ID	DWR_NA0010_18_f_2019_21				
Comment Code					
A3 : No rodents visible, but rodent burrows visible; need to backfill and compact or grout burrows.					
Inspector Comment					
Several large rodent burrows in the landside toe.

Several rodent burrows observed at the landside toe. (Fall 2019)

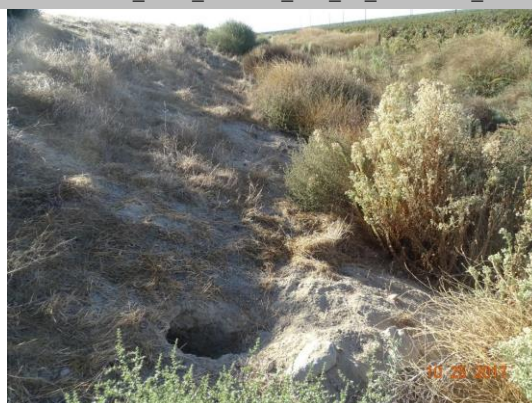
Photo 1 of 1 : FA_2019_NA0010_137_13_20190912_00005.jpg

LM Start	8.67	Rating **	U	Issue No.	13
LM End	8.67	Issue Type +	Ma	Location *	LS
Category	Earthen Levee			GPS Latitude/Longitude	
				Start	End
Item	Animal Control			36.856115 °	36.856115 °
				-120.316595 °	-120.316595 °
DWR ID	DWR_NA0010_18_f_2017_13				
Comment Code					
A3 : No rodents visible, but rodent burrows visible; need to backfill and compact or grout burrows.					
Inspector Comment

Looking south at the landside slope.

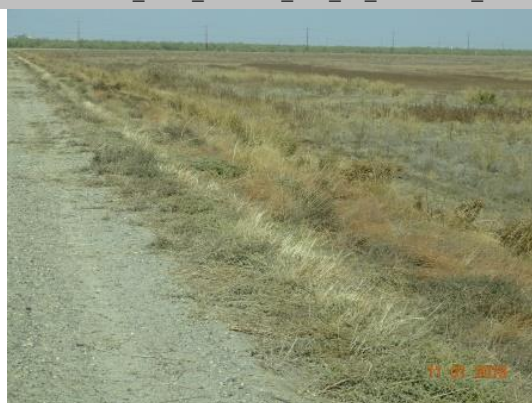
LM Start	9.47	Rating **	U	Issue No.	38
LM End	10.02	Issue Type +	Ma	Location *	WS
Category	Earthen Levee			GPS Latitude/Longitude	
				Start	End
Item	Vegetation			36.844517 °	36.838416 °
				-120.316092 °	-120.310470 °
DWR ID	DWR_NA0010_18_f_2019_38				
Comment Code					
V1 : Control annual grass and weeds on the levee slopes and easements.					
Inspector Comment

Looking downstream along the waterside slope. (Fall 2019)

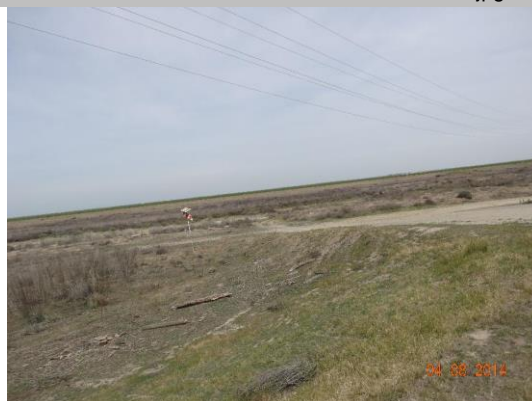
Photo 1 of 3 : UCIP_FA_2019_39505_67226.jpg

LM Start	13.59	Rating **	M	Issue No.	74
LM End	13.59	Issue Type +	En	Location *	
Category	Supplemental			GPS Latitude/Longitude	
				Start	End
Item	DRAFT DWR UCIP Field Study			36.792684 °	36.792684 °
				-120.304542 °	-120.304542 °
DWR ID	19932				
Comment Code					
Inspector Comment					
DS_ID:19932					
FS_ID:39505					
EP_NO: N/A					
Repair Type: Non-Urgent					
Crossing Status: Indicator Found					
UCIP Comments: 04/08/2014 Multiple markers visible along waterward and landward sides unable to confirm how many crossings go through levee. Need to contact owner to obtain additional details on crossings. (DWR UCIP - O. Magana)					
FIELD_STRUCT_DESC: 6-inch natural gas pipeline of an unknown material through the levee. Pipeline extends underneath the channel. [Additional Reference(s): DWR Levee Log, 2002].					
FS Date: 4/8/2014

Markers visible on waterward side.

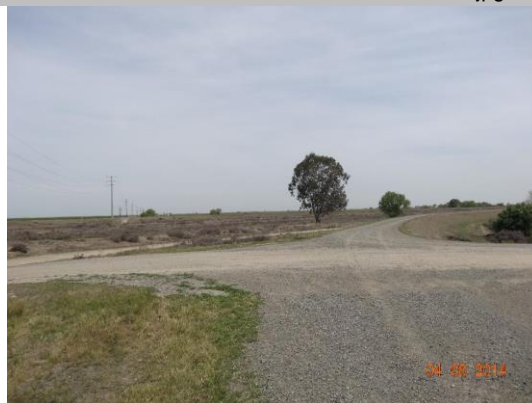
Photo 2 of 3 : UCIP_FA_2019_39505_67225.jpg

View of levee crown at crossing.

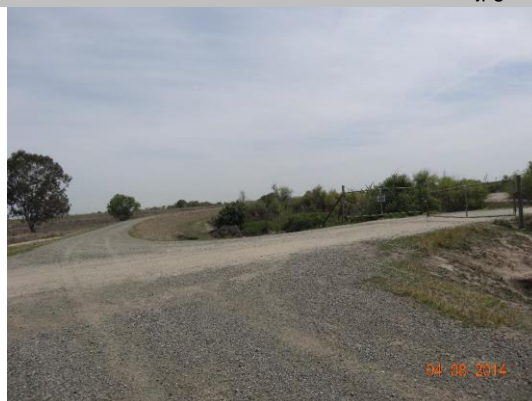
Photo 3 of 3 : UCIP_FA_2019_39505_67224.jpg

LM Start	13.59	Rating **	M	Issue No.	74 (cont)
LM End	13.59	Issue Type +	En	Location *	
Category	Supplemental			GPS Latitude/Longitude	
				Start	End
Item	DRAFT DWR UCIP Field Study			36.792684 °	36.792684 °
				-120.304542 °	-120.304542 °
DWR ID	19932				
Comment Code					
Inspector Comment					
DS_ID:19932 FS_ID:39505 EP_NO: N/A Repair Type: Non-Urgent Crossing Status: Indicator Found UCIP Comments: 04/08/2014 Multiple markers visible along waterward and landward sides unable to confirm how many crossings go through levee. Need to contact owner to obtain additional details on crossings. (DWR UCIP - O. Magana) FIELD_STRUCT_DESC: 6-inch natural gas pipeline of an unknown material through the levee. Pipeline extends underneath the channel. [Additional Reference(s): DWR Levee Log, 2002]. FS Date: 4/8/2014

Ramp visible on landward side.

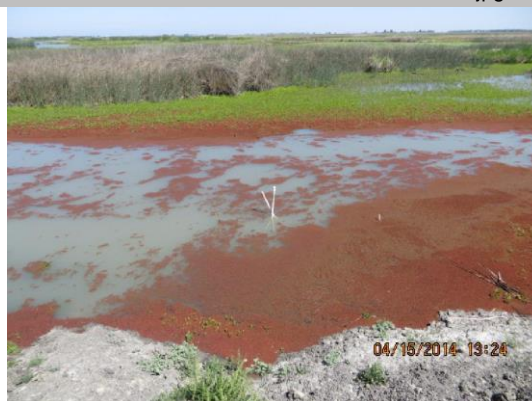
Photo 1 of 3 : UCIP_FA_2019_49959_61060.jpg

Comment Code						
Inspector Comment						
DS_ID:19933						
FS_ID:49959						
EP_NO: N/A						
Repair Type: Non-Urgent						
Crossing Status: Found						
UCIP Comments: 07/19/2016 Gate inside riser appears operable--riser lid damage. Crossing is not visible on LS due to dense vegetation.						
Recommend clearing dense vegetation along WS and LS slope and repairing riser cover. (DWR UCIP - omagana)04/15/2014 No actuator wheel on slide gate at WS shoulder. (DWR UCIP - wwylie)						
FIELD_STRUCT_DESC: 24-inch corrugated metal gravity drainage pipe through the levee, 14.8 feet below the crown. Slide gate in a 36-inch corrugated metal pipe (CMP) riser on the waterside (WS) slope.						
Concrete U-shaped headwall on each end. [Additional Reference(s): DWR Levee Log, 2002. USACE San Joaquin O&M Manual 601.1, 1967, (HLM 0.10)].						
FS Date: 7/19/2016

PVC pipes sticking up out of channel likely indicate pipe location on WS toe.

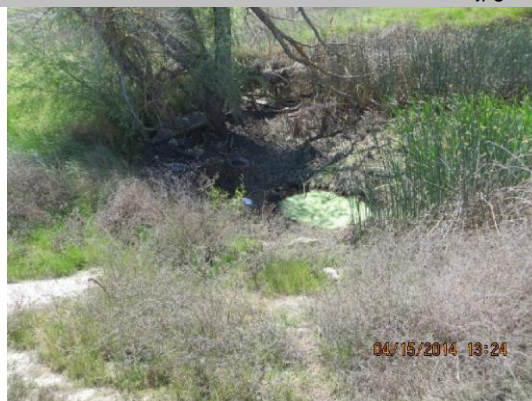
Photo 2 of 3 : UCIP_FA_2019_49959_61061.jpg

Comment Code						
Inspector Comment						
DS_ID:19933 FS_ID:49959 EP_NO: N/A Repair Type: Non-Urgent Crossing Status: Found UCIP Comments: 07/19/2016 Gate inside riser appears operable--riser lid damage. Crossing is not visible on LS due to dense vegetation. Recommend clearing dense vegetation along WS and LS slope and repairing riser cover. (DWR UCIP - omagana)04/15/2014 No actuator wheel on slide gate at WS shoulder. (DWR UCIP - wwylie) FIELD_STRUCT_DESC: 24-inch corrugated metal gravity drainage pipe through the levee, 14.8 feet below the crown. Slide gate in a 36-inch corrugated metal pipe (CMP) riser on the waterside (WS) slope. Concrete U-shaped headwall on each end. [Additional Reference(s): DWR Levee Log, 2002. USACE San Joaquin O&M Manual 601.1, 1967, (HLM 0.10)]. FS Date: 7/19/2016

Concrete headwall at toe of LS slope.

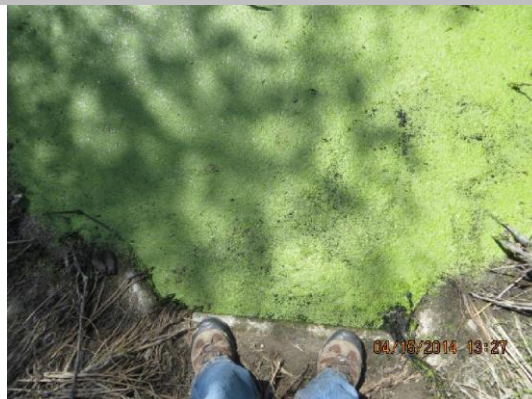
Photo 3 of 3 : UCIP_FA_2019_49959_61059.jpg

Concrete headwall at LS toe.

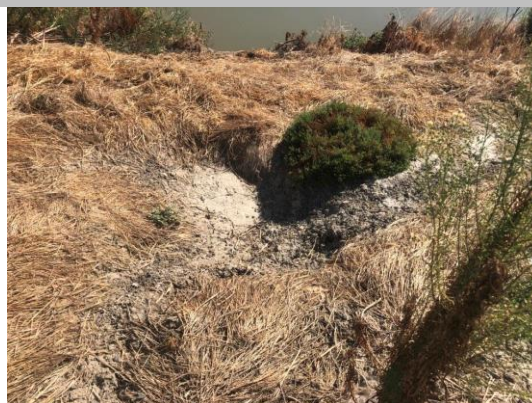
Photo 1 of 3 : SJR2019_DWR_NA0010_22A_f_2018_22_1.JPG

LM Start	1.04	Rating **	M	Issue No.	42
LM End	1.04	Issue Type +	Ma	Location *	
Category	Supplemental			GPS Latitude/Longitude	
				Start	End
Item	DWR Erosion Survey			37.220281 °	37.220281 °
				-120.698287 °	-120.698287 °
DWR ID	NA0010U22RM5.47				
Comment Code					
Inspector Comment					
Site ID: NA0010U22RM5.47					
08/28/2019: Two erosion pockets were found at the site, close to levee shoulder, and likely caused by animal activities.

Looking down at the erosion pocket.

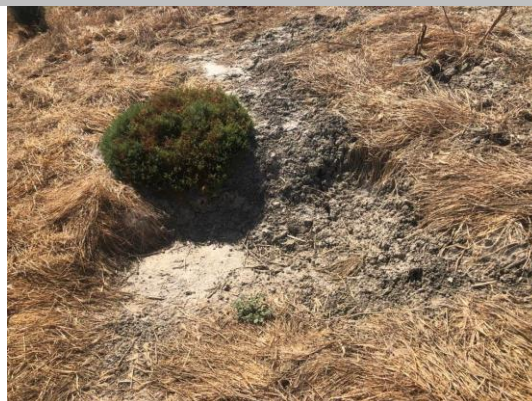
Photo 2 of 3 : SJR2019_DWR_NA0010_22A_f_2018_22_2.JPG

Close view of the erosion.

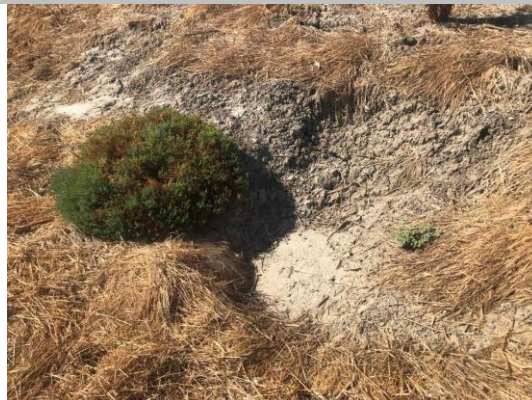
Photo 3 of 3 : SJR2019_DWR_NA0010_22A_f_2018_22_3.JPG

LM Start	1.04	Rating **	M	Issue No.	42 (cont)	
LM End	1.04	Issue Type +	Ma	Location *		
Category	Supplemental			GPS Latitude/Longitude		
				Start	End	
Item	DWR Erosion Survey			37.220281 °	37.220281 °	
				-120.698287 °	-120.698287 °	
DWR ID	NA0010U22RM5.47					
Comment Code						
Inspector Comment						
Site ID: NA0010U22RM5.47						
08/28/2019: Two erosion pockets were found at the site, close to levee shoulder, and likely caused by animal activities.

Close-up view of the erosion.

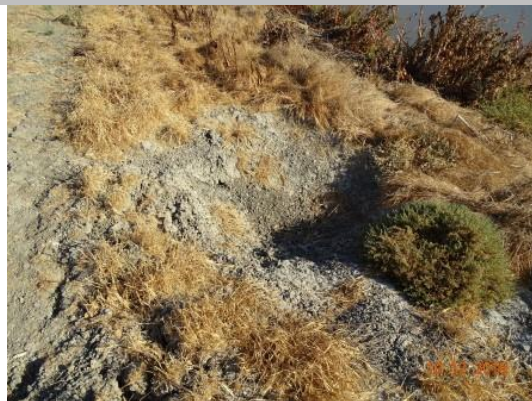
Photo 1 of 1 : FA_2019_NA0010_138_22_20190912_00016.jpg

LM Start	1.04	Rating **	M	Issue No.	22
LM End	1.04	Issue Type +	Ma	Location *	WS
Category	Earthen Levee			GPS Latitude/Longitude	
				Start	End
Item	Erosion / Bank Caving			37.220281 °	37.220281 °
				-120.698287 °	-120.698287 °
DWR ID	DWR_NA0010_22A_f_2018_22				
Comment Code					
E1 : Note and monitor erosion site.					
Inspector Comment					
Depressions are noted on waterside slope.

View of depression on waterside slope. (Fall 2018)

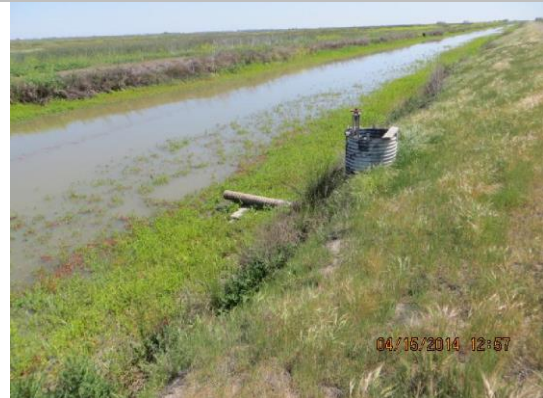
Photo 1 of 3 : UCIP_FA_2019_33733_61030.jpg

Comment Code						
Inspector Comment						
DS_ID:19936 FS_ID:33733 EP_NO: N/A Repair Type: Non-Urgent Crossing Status: Found UCIP Comments: 04/15/2014 Slide gate rusted and does not function. Headwall burried at LS toe. Pipe appears abandoned and if so should be done so properly. (DWR UCIP - W. Wylie) FIELD_STRUCT_DESC: 8-inch corrugated metal gravity irrigation pipe through the levee, 7 feet below the crown. Slide gate in a 36-inch corrugated metal pipe (CMP) riser on the waterside (WS) slope. Concrete headwall on the landside (LS) end. [Additional Reference(s): DWR Levee Log, 2002. USACE San Joaquin O&M Manual 601.1, 1967, (HLM 1.57)]. FS Date: 4/15/2014

Pipe and CMP riser with slide gate visible on WS slope.

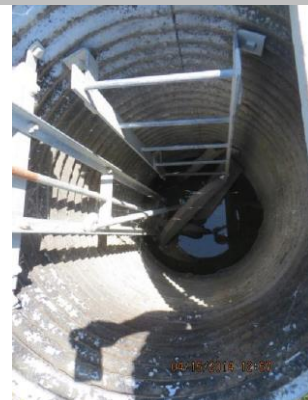
Photo 2 of 3 : UCIP_FA_2019_33733_61029.jpg

Inside CMP riser on WS shoulder.

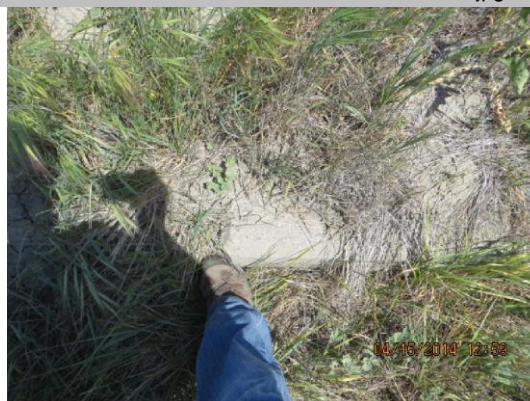
Photo 3 of 3 : UCIP_FA_2019_33733_61028.jpg

Comment Code						
Inspector Comment						
DS_ID:19936 FS_ID:33733 EP_NO: N/A Repair Type: Non-Urgent Crossing Status: Found UCIP Comments: 04/15/2014 Slide gate rusted and does not function. Headwall burried at LS toe. Pipe appears abandoned and if so should be done so properly. (DWR UCIP - W. Wylie) FIELD_STRUCT_DESC: 8-inch corrugated metal gravity irrigation pipe through the levee, 7 feet below the crown. Slide gate in a 36-inch corrugated metal pipe (CMP) riser on the waterside (WS) slope. Concrete headwall on the landside (LS) end. [Additional Reference(s): DWR Levee Log, 2002. USACE San Joaquin O&M Manual 601.1, 1967, (HLM 1.57)]. FS Date: 4/15/2014

Buried concrete headwall on LS toe.

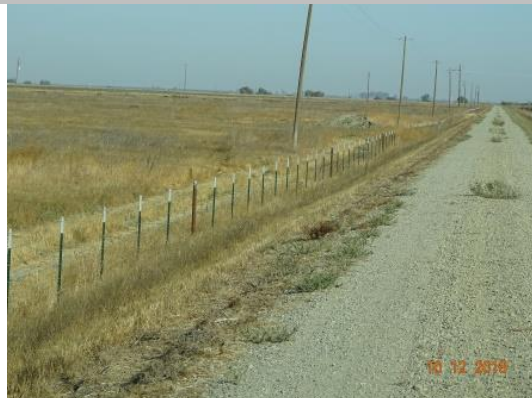
Photo 1 of 1 : FA_2019_NA0010_138_28_20190912_00018.jpg

LM Start	1.75	Rating **	M	Issue No.	28
LM End	2.60	Issue Type +	En	Location *	LS
Category	Earthen Levee			GPS Latitude/Longitude	
				Start	End
Item	Encroachments			37.230585 °	37.242371 °
				-120.702045 °	-120.706371 °
DWR ID	DWR_NA0010_22A_f_2018_28				
Comment Code					
FE : Fence					
Inspector Comment					
A fence is located along the landside toe.

View of fence along landside toe. (Fall 2018)

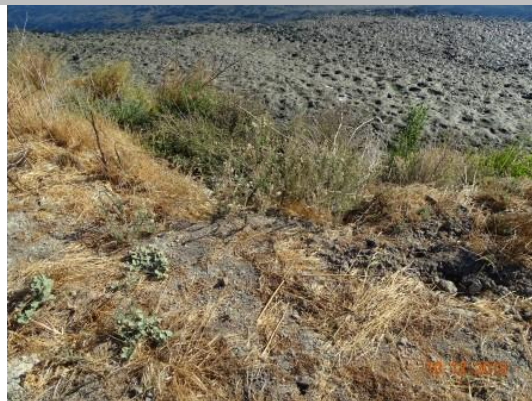
Photo 1 of 2 : FA_2019_NA0010_138_29_20190912_00019.jpg

LM Start	2.20	Rating **	M	Issue No.	29	
LM End	2.37	Issue Type +	Ma	Location *	WS	
Category	Earthen Levee			GPS Latitude/Longitude		
				Start		End
Item	Erosion / Bank Caving			37.236392 °		37.238776 °
				-120.704165 °		-120.705028 °
DWR ID	DWR_NA0010_22A_f_2018_29					
Comment Code						
E1 : Note and monitor erosion site.						
Inspector Comment						
There is slope erosion from livestock, the slope is no longer 3:1. Monitor site.

View of waterside slope from levee crown. (Fall 2018)

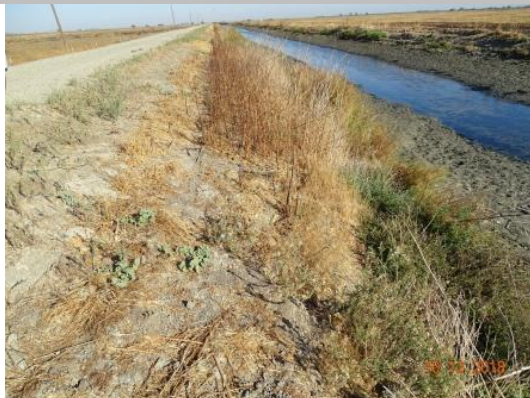
Photo 2 of 2 : FA_2019_NA0010_138_29_20190912_00020.jpg

LM Start	2.20	Rating **	M	Issue No.	29 (cont)	
LM End	2.37	Issue Type +	Ma	Location *	WS	
Category	Earthen Levee			GPS Latitude/Longitude		
				Start		End
Item	Erosion / Bank Caving			37.236392°	37.238776°	
				-120.704165°	-120.705028°	
DWR ID	DWR_NA0010_22A_f_2018_29					
Comment Code						
E1 : Note and monitor erosion site.						
Inspector Comment						
There is slope erosion from livestock, the slope is no longer 3:1. Monitor site.

Looking downstream along waterside slope. (Fall 2018)

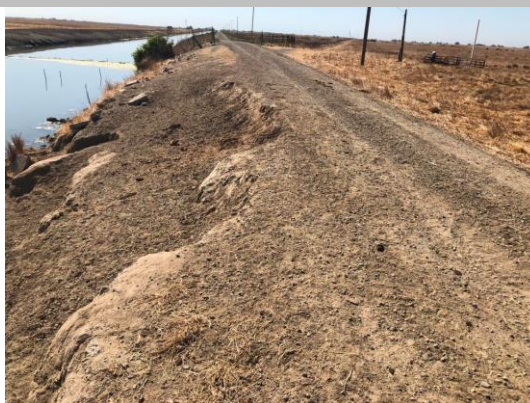
Photo 1 of 3 : SJR2019_DWR_NA0010_22A_s_2017_7_3.JPG

LM Start	2.65	Rating **	U	Issue No.	41
LM End	2.66	Issue Type +	Ma	Location *	
Category	Supplemental			GPS Latitude/Longitude	
				Start	End
Item	DWR Erosion Survey			37.242595 °	37.242595 °
				-120.706470 °	-120.706470 °
DWR ID	NA0010U22RM3.87				
Comment Code					
Inspector Comment					
Site ID: NA0010U22RM3.87					
09/12/2019: The erosion has cut into the levee prism and damaged almost half of the levee. The livestock traffic has likely caused the erosion.

Looking down at the erosion pocket.

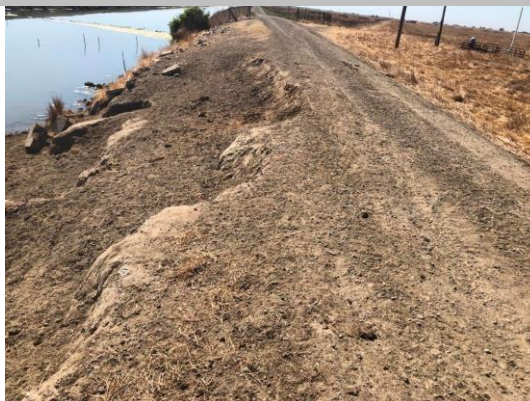
Photo 2 of 3 : SJR2019_DWR_NA0010_22A_s_2017_7_4.JPG

Close view of the erosion.

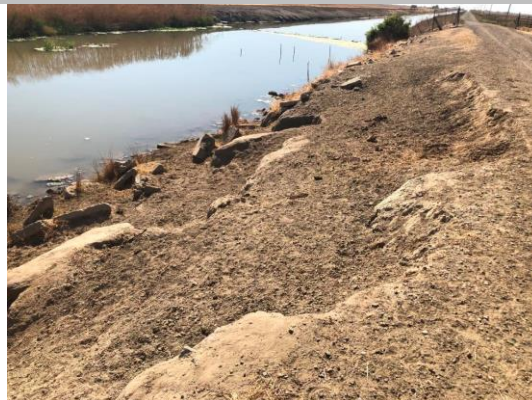
Photo 3 of 3 : SJR2019_DWR_NA0010_22A_s_2017_7_2.JPG

LM Start	2.65	Rating **	U	Issue No.	41 (cont)	
LM End	2.66	Issue Type +	Ma	Location *		
Category	Supplemental			GPS Latitude/Longitude		
				Start	End	
Item	DWR Erosion Survey			37.242595 °	37.242595 °	
				-120.706470 °	-120.706470 °	
DWR ID	NA0010U22RM3.87					
Comment Code						
Inspector Comment						
Site ID: NA0010U22RM3.87						
09/12/2019: The erosion has cut into the levee prism and damaged almost half of the levee. The livestock traffic has likely caused the erosion.

Close-up view of the erosion.

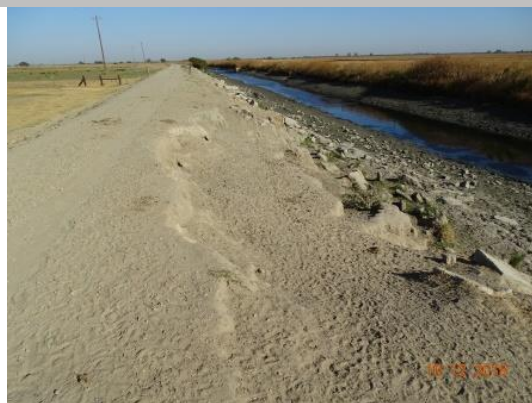
Photo 1 of 3 : FA_2019_NA0010_138_7_20190912_00005.jpg

LM Start	2.65	Rating **	U	Issue No.	7
LM End	2.65	Issue Type +	Ma	Location *	WS
Category	Earthen Levee			GPS Latitude/Longitude	
				Start	End
Item	Erosion / Bank Caving			37.242595 °	37.242595 °
				-120.706470 °	-120.706470 °
DWR ID	DWR_NA0010_22A_s_2017_7				
Comment Code					
E2 : Schedule repair of erosion site prior to the next inspection.					
Inspector Comment					
Erosion is cutting into the crown.

Looking downstream at erosion on waterside slope and shoulder. (Fall 2018)

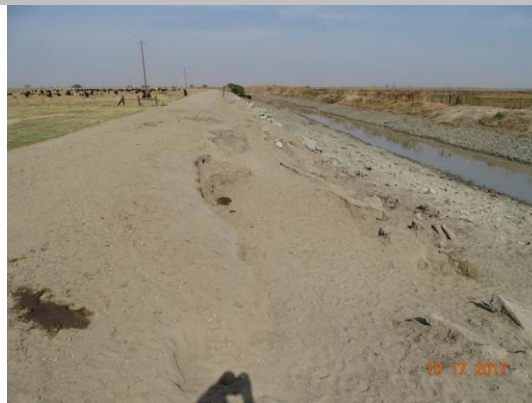
Photo 2 of 3 : FA_2019_NA0010_138_7_20190912_00006.jpg

Looking northwest at the waterside shoulder. (Fall 2017)

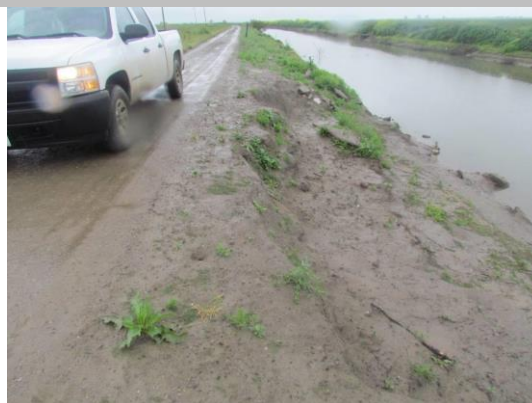
Photo 3 of 3 : FA_2019_NA0010_138_7_20190912_00007.jpg

LM Start	2.65	Rating **	U	Issue No.	7 (cont)	
LM End	2.65	Issue Type +	Ma	Location *	WS	
Category	Earthen Levee			GPS Latitude/Longitude		
				Start		End
Item	Erosion / Bank Caving			37.242595°	37.242595°	
				-120.706470°	-120.706470°	
DWR ID	DWR_NA0010_22A_s_2017_7					
Comment Code						
E2 : Schedule repair of erosion site prior to the next inspection.						
Inspector Comment						
Erosion is cutting into the crown.

Looking downstream at erosion on waterward shoulder and slope.

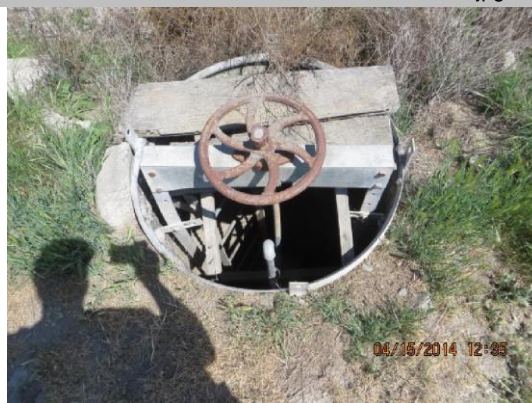
Photo 1 of 3 : UCIP_FA_2019_33732_61026.jpg

LM Start	2.71	Rating **	M	Issue No.	262
LM End	2.71	Issue Type +	En	Location *	
Category	Supplemental			GPS Latitude/Longitude	
				Start	End
Item	DRAFT DWR UCIP Field Study			37.243501°	37.243501°
				-120.706773°	-120.706773°
DWR ID	19937				
Comment Code					
Inspector Comment					
DS_ID:19937 FS_ID:33732 EP_NO: N/A Repair Type: Non-Urgent Crossing Status: Found UCIP Comments: 04/15/2014 Slide gate does not function and should be repaired. Headwall at LS toe not found. (DWR UCIP - W. Wylie) FIELD_STRUCT_DESC: 24-inch corrugated metal irrigation siphon pipe through the levee, 7.5 feet below the crown. Slide gate in a 36-inch corrugated metal pipe (CMP) riser on the waterside (WS) slope. Concrete U-shaped headwall on the landside (LS) end. [Additional Reference(s): DWR Levee Log, 2002. USACE San Joaquin O&M Manual 601.1, 1967, (HLM 2.72)]. FS Date: 4/15/2014

Slidegate in CMP riser on WS shoulder. (Note: actuator does not work).

Comment Code						
Inspector Comment						
DS_ID:19937						
FS_ID:33732						
EP_NO: N/A						
Repair Type: Non-Urgent						
Crossing Status: Found						
UCIP Comments: 04/15/2014 Slide gate does not function and should be repaired. Headwall at LS toe not found. (DWR UCIP - W. Wylie)						
FIELD_STRUCT_DESC: 24-inch corrugated metal irrigation siphon pipe through the levee, 7.5 feet below the crown. Slide gate in a 36-inch corrugated metal pipe (CMP) riser on the waterside (WS) slope.						
Concrete U-shaped headwall on the landside (LS) end. [Additional Reference(s): DWR Levee Log, 2002. USACE San Joaquin O&M Manual 601.1, 1967, (HLM 2.72)].						
FS Date: 4/15/2014

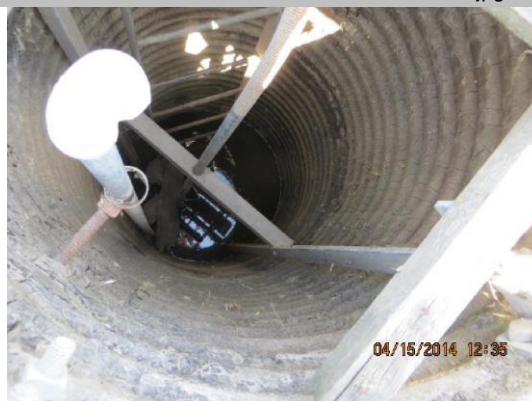
Photo 2 of 3 : UCIP_FA_2019_33732_61024.jpg

Inside CMP riser on WS shoulder.

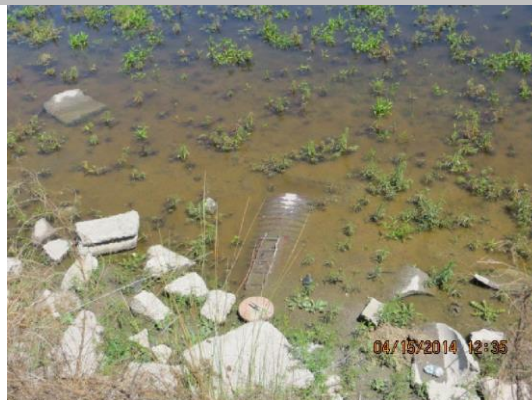
Photo 3 of 3 : UCIP_FA_2019_33732_61025.jpg

Pipe visible on WS toe.

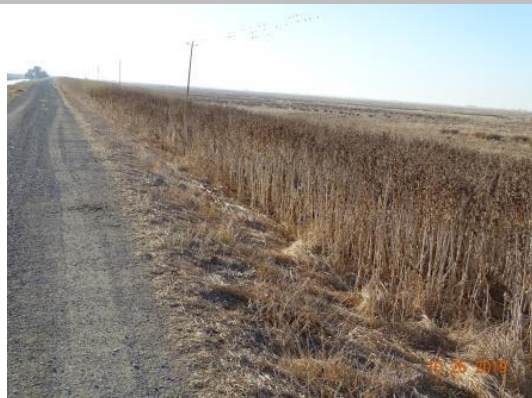
Photo 1 of 1 : FA_2019_NA0010_138_17_20191114_00043.jpg

LM Start	2.73	Rating **	U	Issue No.	17
LM End	3.42	Issue Type +	Ma	Location *	LS
Category	Earthen Levee			GPS Latitude/Longitude	
				Start	End
Item	Vegetation			37.243673 °	37.251167 °
				-120.706843 °	-120.715135 °
DWR ID	DWR_NA0010_22A_f _ 2019_17				
Comment Code					
V1 : Control annual grass and weeds on the levee slopes and easements.					
Inspector Comment

View of vegetation along the landside slope and toe. (Fall 2019)

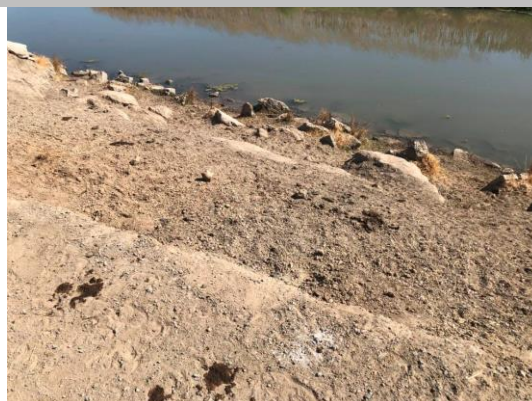
Photo 1 of 3 : SJR2019_DWR_NA0010_22A_f_2018_30_1.jpg

LM Start	2.82	Rating **	U	Issue No.	40
LM End	2.83	Issue Type +	Ma	Location *	
Category	Supplemental			GPS Latitude/Longitude	
				Start	End
Item	DWR Erosion Survey			37.244940 °	37.244940 °
				-120.707467 °	-120.707467 °
DWR ID	NA0010U22RM3.7				
Comment Code					
Inspector Comment					
Site ID: NA0010U22RM3.7					
09/12/2019: The erosion has damaged entire levee slope. The livestock traffic likely has caused the erosion.

Looking down at the erosion pocket.

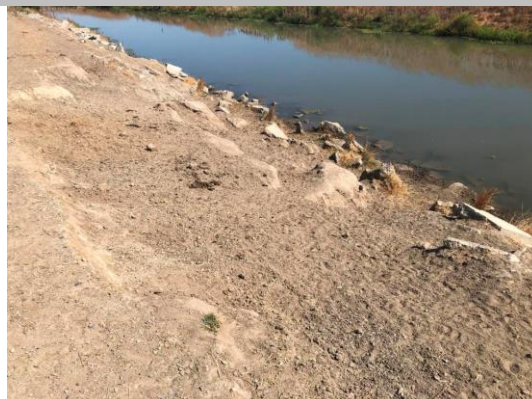
Photo 2 of 3 : SJR2019_DWR_NA0010_22A_f_2018_30_2.jpg

Close view of the erosion.

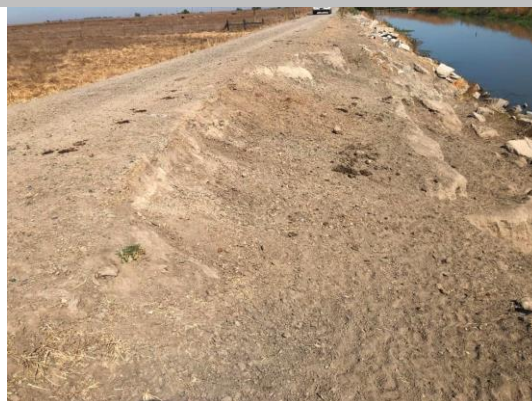
Photo 3 of 3 : SJR2019_DWR_NA0010_22A_f_2018_30_3.JPG

LM Start	2.82	Rating **	U	Issue No.	40 (cont)	
LM End	2.83	Issue Type +	Ma	Location *		
Category	Supplemental			GPS Latitude/Longitude		
				Start	End	
Item	DWR Erosion Survey			37.244940 °	37.244940 °	
				-120.707467 °	-120.707467 °	
DWR ID	NA0010U22RM3.7					
Comment Code						
Inspector Comment						
Site ID: NA0010U22RM3.7						
09/12/2019: The erosion has damaged entire levee slope. The livestock traffic likely has caused the erosion.

Close-up view of the erosion.

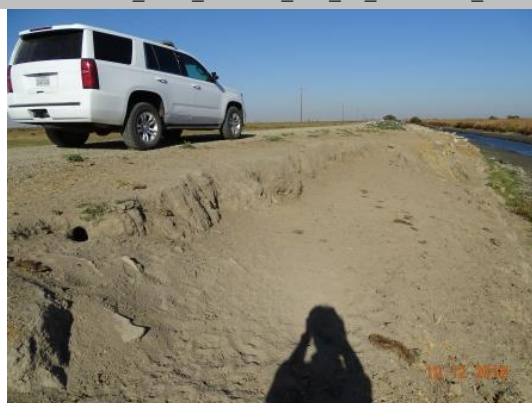
Photo 1 of 2 : FA_2019_NA0010_138_30_20190912_00021.jpg

LM Start	2.82	Rating **	U	Issue No.	30
LM End	2.83	Issue Type +	Ma	Location *	WS
Category	Earthen Levee			GPS Latitude/Longitude	
				Start	End
Item	Erosion / Bank Caving			37.244940 °	37.245050 °
				-120.707467 °	-120.707567 °
DWR ID	DWR_NA0010_22A_f _ 2018_30				
Comment Code					
E2 : Schedule repair of erosion site prior to the next inspection.					
Inspector Comment					
Erosion is cutting into the waterside bank.

View of erosion in waterside slope. (Fall 2018)

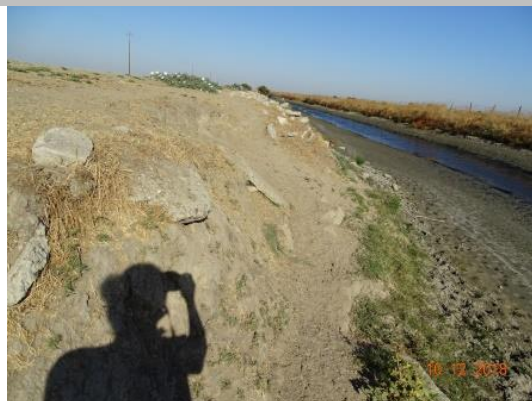
Photo 2 of 2 : FA_2019_NA0010_138_30_20190912_00022.jpg

View along waterside slope. (Fall 2018)

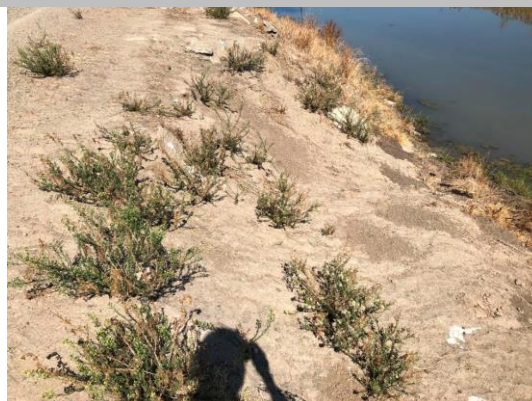
Photo 1 of 3 : SJR2019_DWR_NA0010_22A_f_2018_31_3.jpg

LM Start	2.87	Rating **	U	Issue No.	39	
LM End	2.87	Issue Type +	Ma	Location *		
Category	Supplemental			GPS Latitude/Longitude		
				Start		End
Item	DWR Erosion Survey			37.245536 °	37.245536 °	
				-120.708119 °	-120.708119 °	
DWR ID	NA0010U22RM3.65					
Comment Code						
Inspector Comment						
Site ID: NA0010U22RM3.65						
09/12/2019: The erosion has damaged entire levee slope. The livestock traffic likely has caused the erosion.

Looking down at the erosion pocket.

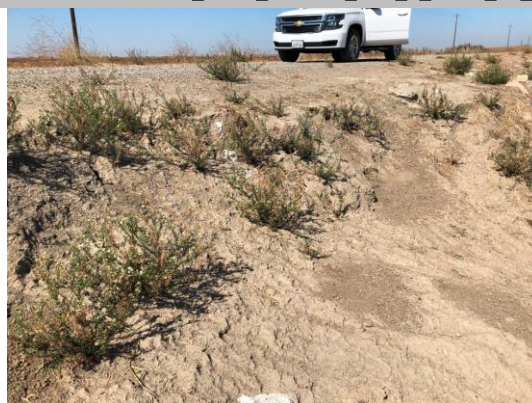
Photo 2 of 3 : SJR2019_DWR_NA0010_22A_f_2018_31_4.jpg

Close view of the erosion.

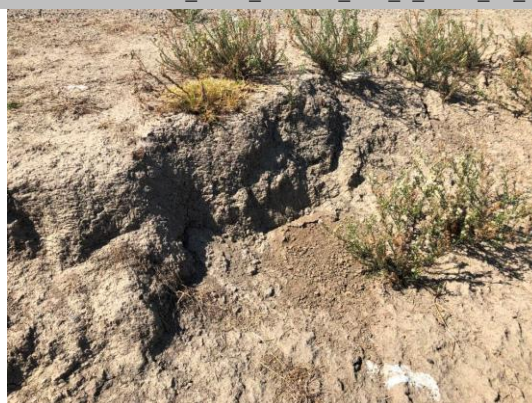
Photo 3 of 3 : SJR2019_DWR_NA0010_22A_f_2018_31_6.JPG

Close-up view of the erosion.

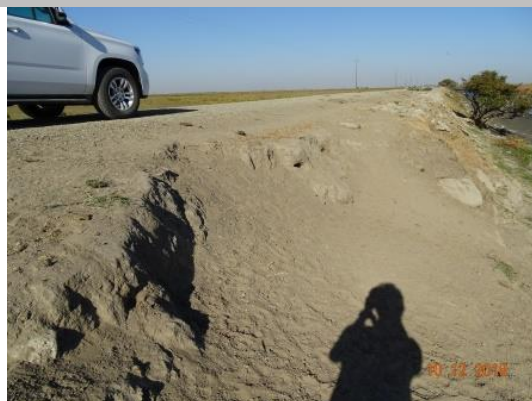
Photo 1 of 1 : FA_2019_NA0010_138_31_20190912_00023.jpg

LM Start	2.87	Rating **	U	Issue No.	31
LM End	2.87	Issue Type +	Ma	Location *	WS
Category	Earthen Levee			GPS Latitude/Longitude	
				Start	End
Item	Erosion / Bank Caving			37.245536°	37.245536°
				-120.708119°	-120.708119°
DWR ID	DWR_NA0010_22A_f_2018_31				
Comment Code					
E2 : Schedule repair of erosion site prior to the next inspection.					
Inspector Comment					
Erosion is cutting into the waterside shoulder.

View of waterside slope looking downstream. (Fall 2018)

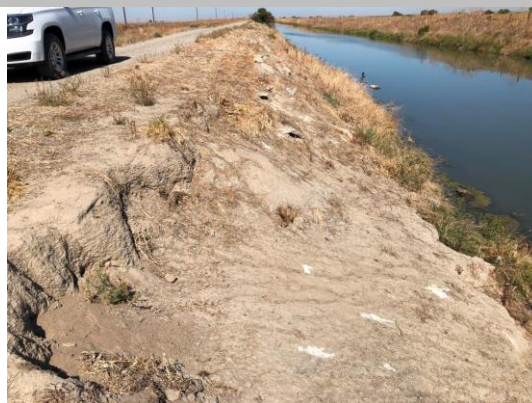
Photo 1 of 3 : SJR2019_DWR_NA0010_22A_f_2018_32_6.jpg

LM Start	2.96	Rating **	U	Issue No.	38	
LM End	2.97	Issue Type +	Ma	Location *		
Category	Supplemental			GPS Latitude/Longitude		
				Start	End	
Item	DWR Erosion Survey			37.246408 °	37.246408 °	
				-120.709197 °	-120.709197 °	
DWR ID	NA0010U22RM3.56					
Comment Code						
Inspector Comment						
Site ID: NA0010U22RM3.56						
09/12/2019: The erosion has damaged entire levee slope. The livestock activity likely has caused the erosion.

Looking down at the erosion pocket.

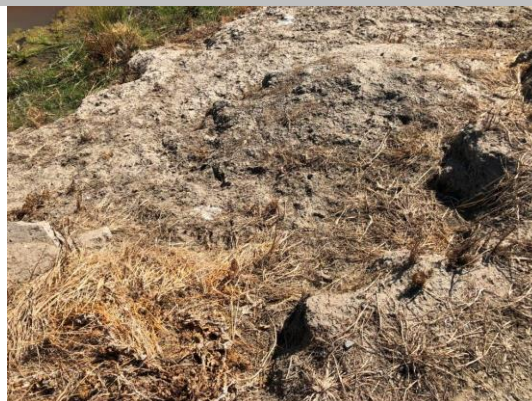
Photo 2 of 3 : SJR2019_DWR_NA0010_22A_f_2018_32_2.jpg

Close-up view of the erosion.

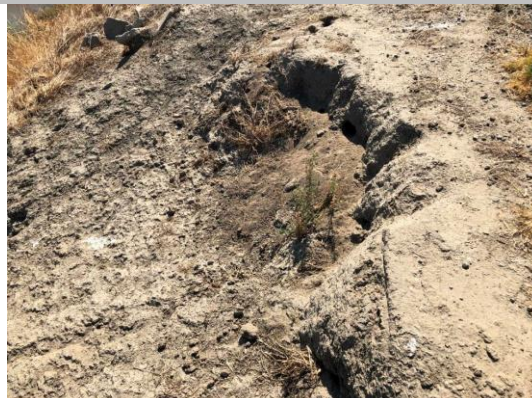
Photo 3 of 3 : SJR2019_DWR_NA0010_22A_f_2018_32_4.JPG

LM Start	2.96	Rating **	U	Issue No.	38 (cont)	
LM End	2.97	Issue Type +	Ma	Location *		
Category	Supplemental			GPS Latitude/Longitude		
				Start	End	
Item	DWR Erosion Survey			37.246408 °	37.246408 °	
				-120.709197 °	-120.709197 °	
DWR ID	NA0010U22RM3.56					
Comment Code						
Inspector Comment						
Site ID: NA0010U22RM3.56						
09/12/2019: The erosion has damaged entire levee slope. The livestock activity likely has caused the erosion.

Close-up view of the erosion.

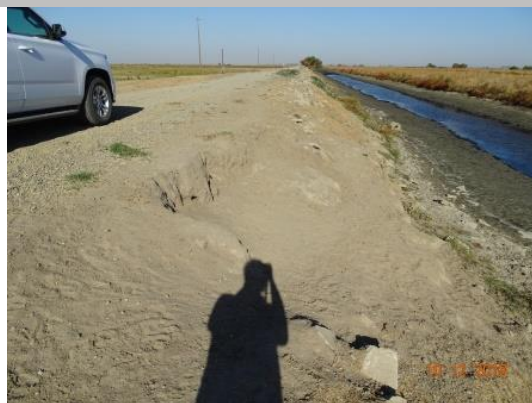
Photo 1 of 1 : FA_2019_NA0010_138_32_20190912_00024.jpg

LM Start	2.96	Rating **	U	Issue No.	32
LM End	2.96	Issue Type +	Ma	Location *	WS
Category	Earthen Levee			GPS Latitude/Longitude	
				Start	End
Item	Erosion / Bank Caving			37.246408 °	37.246408 °
				-120.709197 °	-120.709197 °
DWR ID	DWR_NA0010_22A_f _ 2018_32				
Comment Code					
E2 : Schedule repair of erosion site prior to the next inspection.					
Inspector Comment					
Erosion is cutting into the waterside slope.

View of waterside slope erosion. (Fall 2018)

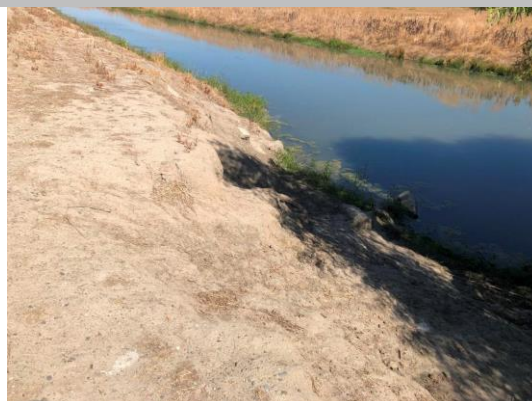
Photo 1 of 3 : SJR2019_DWR_NA0010_22A_f_2018_33_6.JPG

LM Start	3.14	Rating **	U	Issue No.	36	
LM End	3.15	Issue Type +	Ma	Location *		
Category	Supplemental			GPS Latitude/Longitude		
				Start	End	
Item	DWR Erosion Survey			37.248257°	37.248257°	
				-120.711547°	-120.711547°	
DWR ID	NA0010U22RM3.38					
Comment Code						
Inspector Comment						
Site ID: NA0010U22RM3.38						
09/12/2019: The erosion has damaged the entire levee slope. Livestock activity likely has caused the erosion.

Looking down at the erosion pocket.

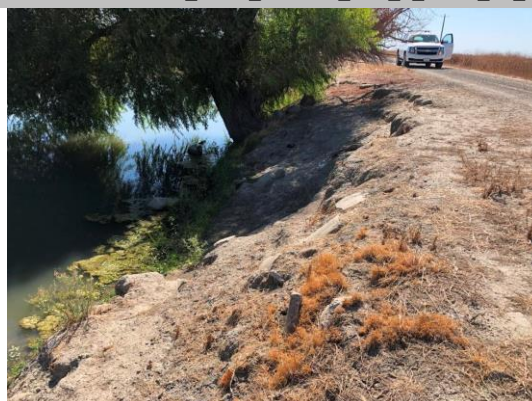
Photo 2 of 3 : SJR2019_DWR_NA0010_22A_f_2018_33_2.JPG

Close-up view of the erosion. Note the willow tree near the site.

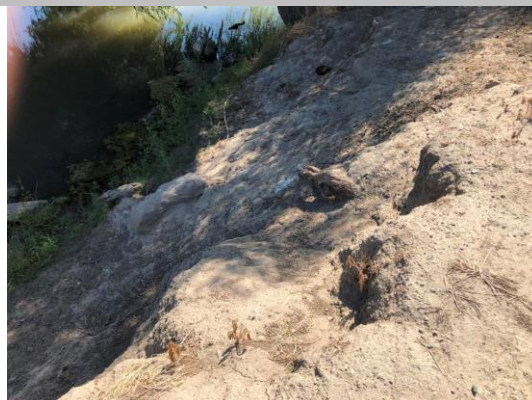
Photo 3 of 3 : SJR2019_DWR_NA0010_22A_f_2018_33_5.JPG

Close-up view of the erosion.

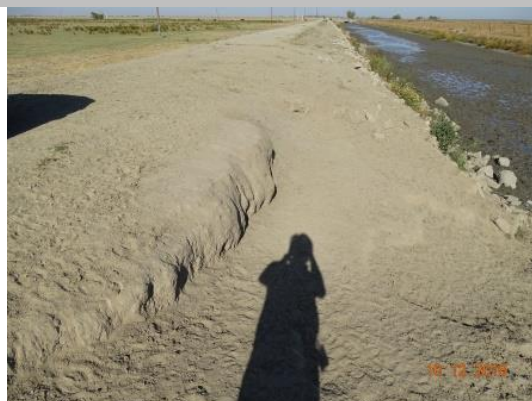
Photo 1 of 1 : FA_2019_NA0010_138_35_20190912_00027.jpg

LM Start	3.47	Rating **	U	Issue No.	35
LM End	3.47	Issue Type +	Ma	Location *	WS
Category	Earthen Levee			GPS Latitude/Longitude	
				Start	End
Item	Erosion / Bank Caving			37.251621°	37.251621°
				-120.715649°	-120.715649°
DWR ID	DWR_NA0010_22A_f_2018_35				
Comment Code					
E2 : Schedule repair of erosion site prior to the next inspection.					
Inspector Comment					
Waterside slope erosion is from livestock activity.

Erosion in waterside slope from livestock. (Fall 2018)

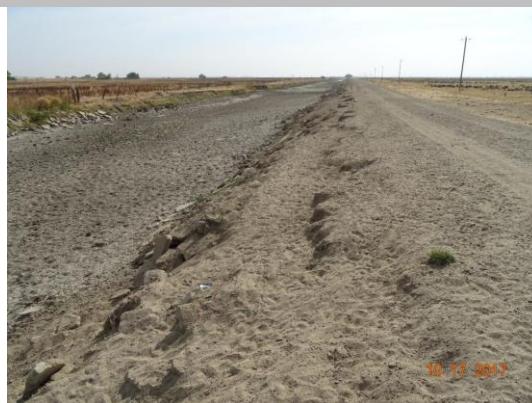
Photo 1 of 2 : FA_2019_NA0010_138_9_20190912_00012.jpg

LM Start	3.64	Rating **	U	Issue No.	9
LM End	3.69	Issue Type +	Ma	Location *	WS
Category	Earthen Levee			GPS Latitude/Longitude	
				Start	End
Item	Erosion / Bank Caving			37.253362 °	37.253862 °
				-120.717873 °	-120.718507 °
DWR ID	DWR_NA0010_22A_f _ 2016_9				
Comment Code					
E2 : Schedule repair of erosion site prior to the next inspection.					
Inspector Comment					
Several erosion or levee damage sites caused by animal traffic are within this section.

Looking southeast at the waterside slope.

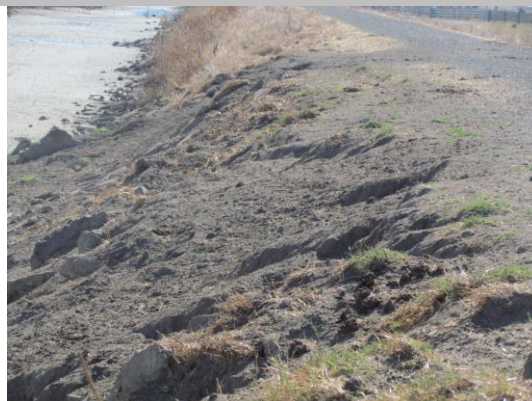
Photo 2 of 2 : FA_2019_NA0010_138_9_20190912_00013.jpg

Looking downstream at animal erosion on waterward slope.

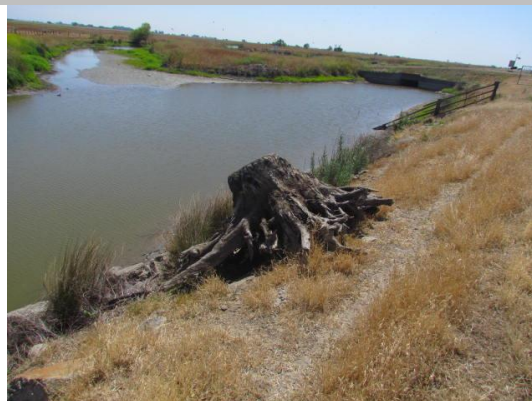
Photo 1 of 1 : FA_2019_NA0010_138_259_20190912_00029.jpg

Looking east at dead stump on waterward slope.

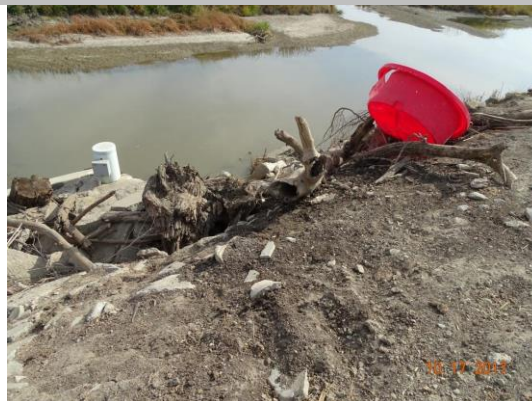
Photo 1 of 1 : FA_2019_NA0010_138_13_20190912_00014.jpg

Looking northeast at the waterside slope.

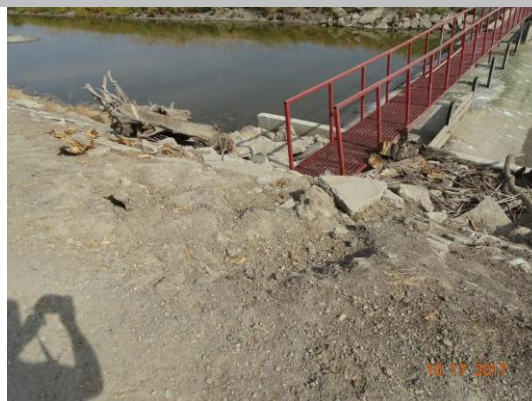
Photo 1 of 1 : FA_2019_NA0010_138_14_20190912_00015.jpg

LM Start	3.82	Rating **	M	Issue No.	14
LM End	3.82	Issue Type +	Ma	Location *	WS
Category	Earthen Levee			GPS Latitude/Longitude	
				Start	End
Item	Slope Stability			37.255239 °	37.255239 °
				-120.720142 °	-120.720142 °
DWR ID	DWR_NA0010_22A_f _ 2017_14				
Comment Code					
S1 : Repair slope instability.					
Inspector Comment

Looking northeast at the waterside slope. (Fall 2017)

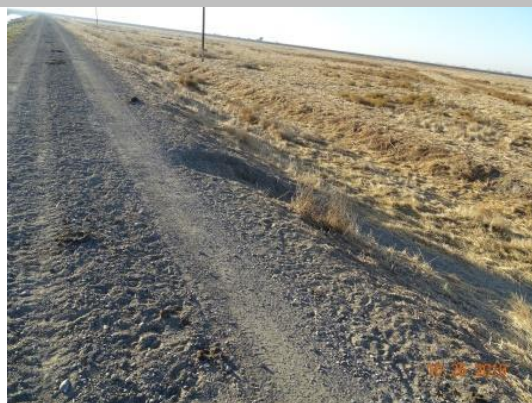
Photo 1 of 1 : FA_2019_NA0010_138_15_20191114_00045.jpg

LM Start	4.11	Rating **	M	Issue No.	15
LM End	4.11	Issue Type +	Ma	Location *	LS
Category	Earthen Levee			GPS Latitude/Longitude	
				Start	End
Item	Slope Stability			37.258353 °	37.258353 °
				-120.723824 °	-120.723824 °
DWR ID	DWR_NA0010_22A_f_2019_15				
Comment Code					
S2 : Repair the levee slope damaged by foot traffic and prevent access where possible.					
Inspector Comment

View of erosion in the landside slope and shoulder from livestock traffic. (Fall 2019)

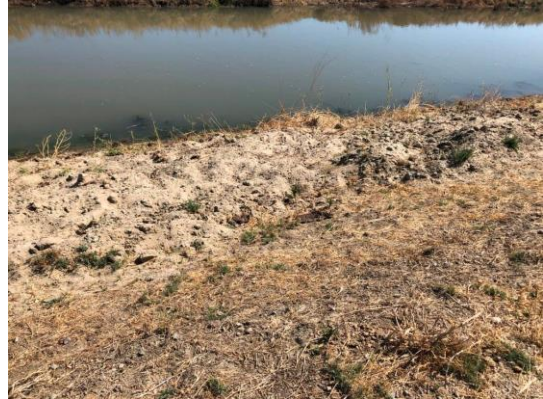
Photo 1 of 3 : SJR2019_DWR_NA0010_22A_f_ 2018_37_1.JPG

LM Start	4.26	Rating **	U	Issue No.	26
LM End	4.30	Issue Type +	Ma	Location *	
Category	Supplemental			GPS Latitude/Longitude	
				Start	End
Item	DWR Erosion Survey			37.260111 °	37.260111 °
				-120.725900 °	-120.725900 °
DWR ID	NA0010U22RM2.25				
Comment Code					
Inspector Comment					
Site ID: NA0010U22RM2.25					
09/12/2019: Erosion has developed into the lower levee slope. Loose material was observed at the site.

Looking down at the erosion pocket.

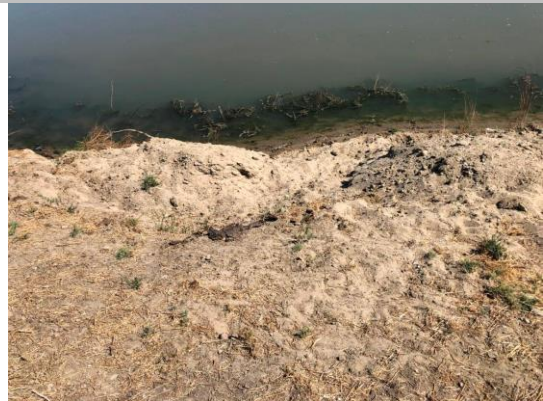
Photo 2 of 3 : SJR2019_DWR_NA0010_22A_f_ 2018_37_3.JPG

Close-up view of the erosion.

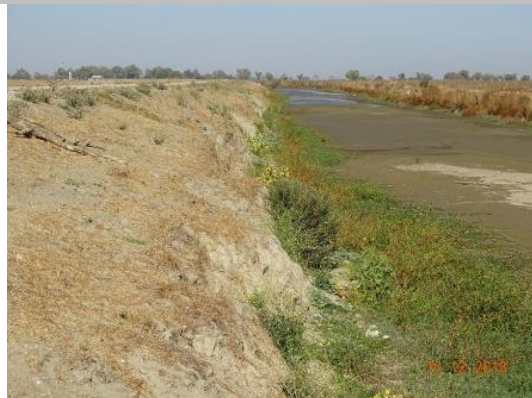
Photo 1 of 1 : FA_2019_NA0010_138_37_20190912_00028.jpg

LM Start	4.28	Rating **	U	Issue No.	37
LM End	5.11	Issue Type +	Ma	Location *	WS
Category	Earthen Levee			GPS Latitude/Longitude	
				Start	End
Item	Erosion / Bank Caving			37.260111 °	37.268135 °
				-120.725900 °	-120.737130 °
DWR ID	DWR_NA0010_22A_f _ 2018_37				
Comment Code					
E2 : Schedule repair of erosion site prior to the next inspection.					
Inspector Comment					
Erosion is cutting into the waterside slope.

View of waterside slope looking downstream. (Fall 2018)

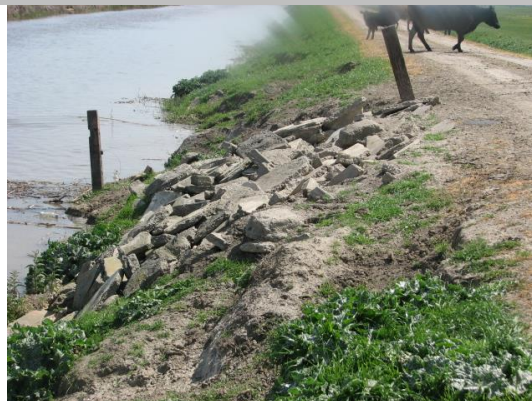
Photo 1 of 4 : FA_2019_NA0010_138_8_20190912_00008.jpg

LM Start	4.87	Rating **	A/W	Issue No.	8
LM End	4.87	Issue Type +	Ma	Location *	WS
Category	Earthen Levee			GPS Latitude/Longitude	
				Start	End
Item	Slope Stability			37.265813 °	37.265813 °
				-120.733748 °	-120.733748 °
DWR ID	DWR_NA0010_22A_f _ 2016_8				
Comment Code					
S1 : Repair slope instability.					
Inspector Comment					
Levee damage caused by animal traffic. Several sites repaired with broken concrete.

Looking downstream at repaired site with concrete rubble on waterward slope and shoulder. (Spring 2018)

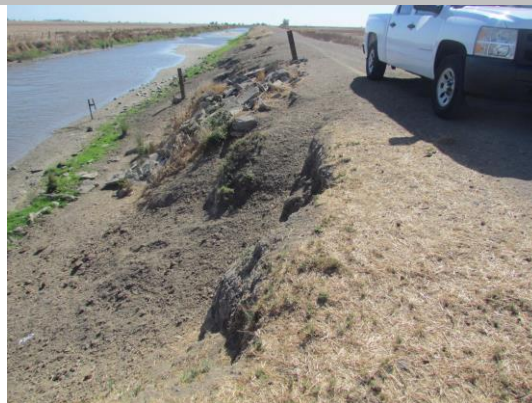
Photo 2 of 4 : FA_2019_NA0010_138_8_20190912_00009.jpg

Looking downstream at animal erosion on waterward slope.

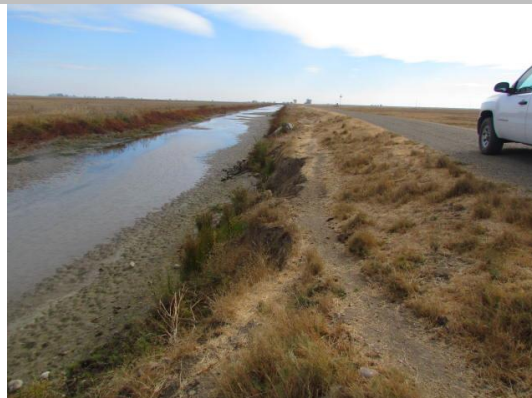
Photo 2 of 2 : FA_2019_NA0010_138_4_20190912_00002.jpg

LM Start	5.05	Rating **	M	Issue No.	4 (cont)	
LM End	5.05	Issue Type +	Ma	Location *	WS	
Category	Earthen Levee			GPS Latitude/Longitude		
				Start		End
Item	Erosion / Bank Caving			37.267516 °	37.267516 °	
				-120.736401 °	-120.736401 °	
DWR ID	DWR_NA0010_22A_f _ 2013_4					
Comment Code						
E2 : Schedule repair of erosion site prior to the next inspection.						
Inspector Comment						
Erosion caused by animal traffic.

Looking southeast at livestock erosion on waterward toe.

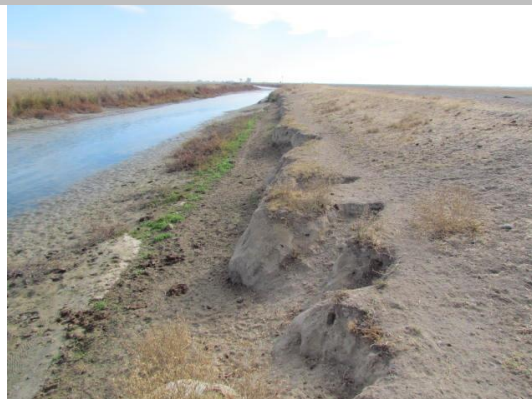
Photo 1 of 2 : FA_2019_NA0010_138_6_20190912_00003.jpg

LM Start	5.12	Rating **	M	Issue No.	6
LM End	5.40	Issue Type +	Ma	Location *	WS
Category	Earthen Levee			GPS Latitude/Longitude	
				Start	End
Item	Slope Stability			37.268236 °	37.271204 °
				-120.737210 °	-120.740585 °
DWR ID	DWR_NA0010_22A_s_2012_6				
Comment Code					
S2 : Repair the levee slope damaged by foot traffic and prevent access where possible.					
Inspector Comment					
Slope damage is caused by livestock on waterside toe.

Looking southeast at livestock erosion on waterward toe.

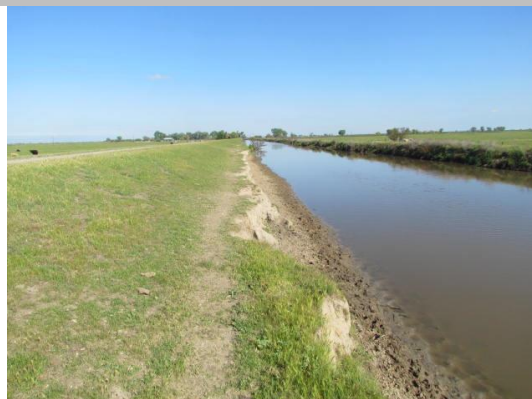
Photo 2 of 2 : FA_2019_NA0010_138_6_20190912_00004.jpg

Looking northwest at livestock erosion along waterside slope and toe.

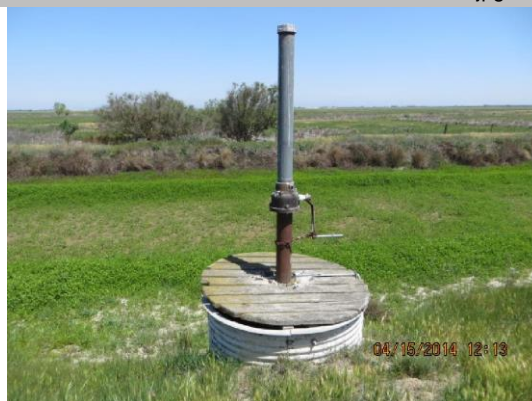
Photo 1 of 3 : UCIP_FA_2019_39536_61022.jpg

Comment Code					
Inspector Comment					
DS_ID:19938 FS_ID:39536 EP_NO: N/A Repair Type: Non-Urgent Crossing Status: Found UCIP Comments: 04/15/2014 Need to contact owner. Pipe silted in on LS toe. Appears abandoned and if so should be done so properly. (DWR UCIP - W. Wylie) FIELD_STRUCT_DESC: 48-inch corrugated metal irrigation siphon pipe through the levee, 10 feet below the crown. Slide gate in a 60-inch corrugated metal pipe (CMP) riser on the waterside (WS) slope. Concrete headwall on the landside (LS) end. WS end capped with a 0.25-inch steel plate. [Additional Reference(s): DWR Levee Log, 2002. USACE San Joaquin O&M Manual 601.1, 1967, (HLM 5.48)]. FS Date: 4/15/2014

Slidegate inside riser on WS shoulder.

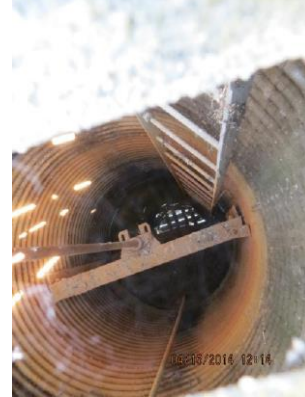
Photo 2 of 3 : UCIP_FA_2019_39536_61021.jpg

Comment Code						
Inspector Comment						
DS_ID:19938						
FS_ID:39536						
EP_NO: N/A						
Repair Type: Non-Urgent						
Crossing Status: Found						
UCIP Comments: 04/15/2014 Need to contact owner. Pipe silted in on						
LS toe. Appears abandoned and if so should be done so properly.						
(DWR UCIP - W. Wylie)						
FIELD_STRUCT_DESC: 48-inch corrugated metal irrigation siphon pipe						
through the levee, 10 feet below the crown. Slide gate in a 60-inch						
corrugated metal pipe (CMP) riser on the waterside (WS) slope.						
Concrete headwall on the landside (LS) end. WS end capped with a

Inside riser on WS shoulder.

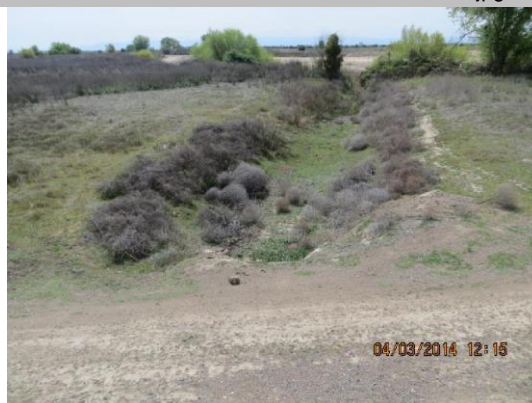
Photo 1 of 3 : UCIP_FA_2019_39537_59860.jpg

Comment Code					
Inspector Comment					
DS_ID:19945 FS_ID:39537 EP_NO: N/A Repair Type: Non-Urgent Crossing Status: Found UCIP Comments: 04/03/2014 Excessive vegetation at inlet--recommend clearing. (DWR UCIP - W. Wylie) FIELD_STRUCT_DESC: 30-inch by 30-inch square reinforced concrete box gravity drainage culvert through the levee, 13 feet below the crown. Flap gate on the waterside (WS) end. Concrete headwall on the landside (LS) end. Concrete U-shaped headwall on the WS end. (Plans to construct a new discharge structure and to rehabilitate one existing diversion structure to return intercepted seepage to the San Joaquin River authorized under Permit No. 13085, 1981 - Diener, Dry River Farms). [Additional Reference(s): DWR Levee Log, 2002. USACE San Joaquin O&M Manual 601.1, 1967, (HLM 0.21)]. FS Date: 4/3/2014

Concrete headwall on WS toe at channel.

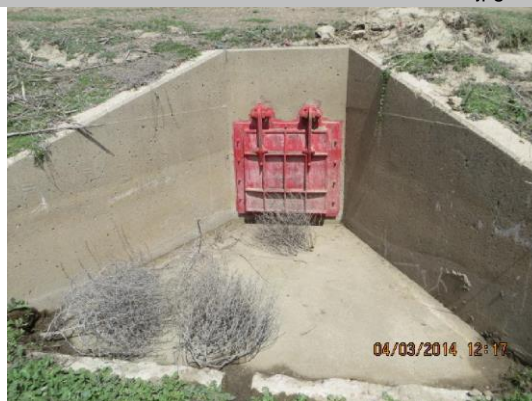
Photo 2 of 3 : UCIP_FA_2019_39537_59859.jpg

Comment Code						
Inspector Comment						
DS_ID:19945 FS_ID:39537 EP_NO: N/A Repair Type: Non-Urgent Crossing Status: Found UCIP Comments: 04/03/2014 Excessive vegetation at inlet--recommend clearing. (DWR UCIP - W. Wylie) FIELD_STRUCT_DESC: 30-inch by 30-inch square reinforced concrete box gravity drainage culvert through the levee, 13 feet below the crown. Flap gate on the waterside (WS) end. Concrete headwall on the landside (LS) end. Concrete U-shaped headwall on the WS end. (Plans to construct a new discharge structure and to rehabilitate one existing diversion structure to return intercepted seepage to the San Joaquin River authorized under Permit No. 13085, 1981 - Diener, Dry River Farms). [Additional Reference(s): DWR Levee Log, 2002. USACE San Joaquin O&M Manual 601.1, 1967, (HLM 0.21)]. FS Date: 4/3/2014

Flapgate on Concrete headwall at WS toe.

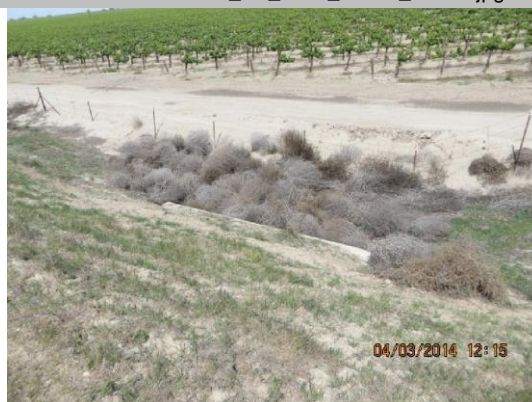
Photo 3 of 3 : UCIP_FA_2019_39537_59861.jpg

Concrete headwall at LS toe. Excess vegetation buildup at inlet.
