**Flood Control Project Maintenance
Levee Inspections**

Fall 2019 Levee Maintenance Deficiency Summary Report

San Joaquin River Basin

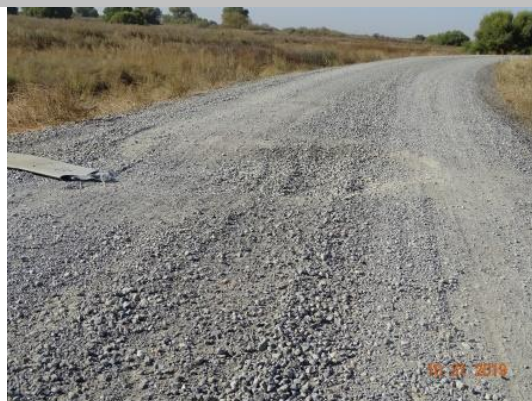
Photo 1 of 1 : FA_2019_NA0010_139_29_20191114_00039.jpg

LM Start	0.39	Rating **	M	Issue No.	29
LM End	0.39	Issue Type +	Ma	Location *	CR
Category	Earthen Levee			GPS Latitude/Longitude	
				Start	End
Item	Crown Surface / Depressions / Rutting			36.772233 °	36.772233 °
				-120.277532 °	-120.277532 °
DWR ID	DWR_NA0010_23_f_2019_29				
Comment Code					
C2 : Repair depressions or ruts in the crown or slope.					
Inspector Comment

View of depression in the levee crown. (Fall 2019)

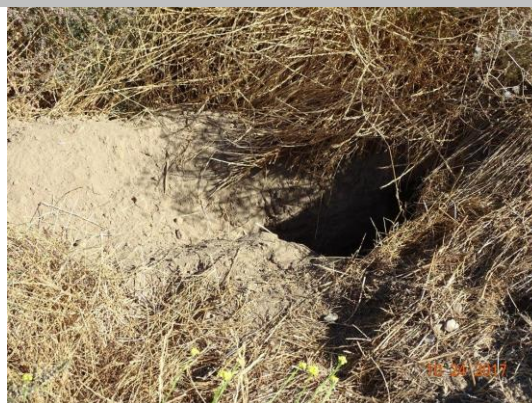
Photo 1 of 1 : FA_2019_NA0010_139_26_20190912_00005.jpg

LM Start	1.09	Rating **	U	Issue No.	26
LM End	1.09	Issue Type +	Ma	Location *	LS
Category	Earthen Levee			GPS Latitude/Longitude	
				Start	End
Item	Animal Control			36.772743 °	36.772743 °
				-120.266800 °	-120.266800 °
DWR ID	DWR_NA0010_23_f_2017_26				
Comment Code					
A3 : No rodents visible, but rodent burrows visible; need to backfill and compact or grout burrows.					
Inspector Comment					
Need to repair the large rodent hole on the landside slope.

Looking at the landside slope.

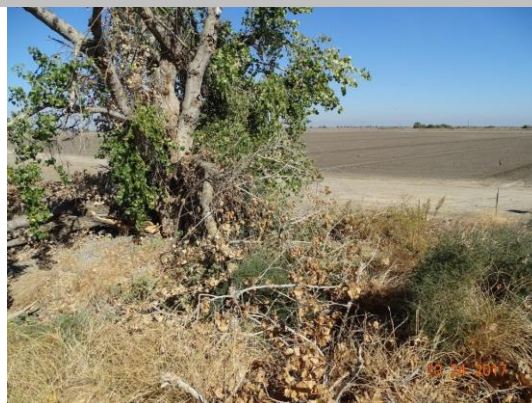
Photo 1 of 1 : FA_2019_NA0010_139_28_20190912_00006.jpg

LM Start	1.52	Rating **	M	Issue No.	28
LM End	1.52	Issue Type +	Ma	Location *	LS
Category	Earthen Levee			GPS Latitude/Longitude	
				Start	End
Item	Encroachments			36.772066 °	36.772066 °
				-120.259545 °	-120.259545 °
DWR ID	DWR_NA0010_23_f_2017_28				
Comment Code					
TR : Tree or limb					
Inspector Comment					
There are downed tree limbs on the landside slope.

Looking north at landside slope.

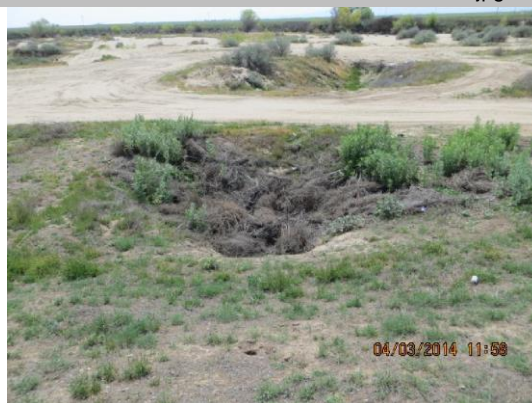
Photo 1 of 3 : UCIP_FA_2019_39538_59855.jpg

Comment Code					
Inspector Comment					
DS_ID:19948					
FS_ID:39538					
EP_NO: N/A					
Repair Type: Non-Urgent					
Crossing Status: Found					
UCIP Comments: 04/03/2014 Appears abandoned and if so should be done properly. Discharge channel is blocked by sand and soil making drain ineffective. Soil buildup at inlet on LS toe. Need to contact owner. (DWR UCIP - W. Wylie)					
FIELD_STRUCT_DESC: 30-inch by 30-inch square reinforced concrete box gravity drainage culvert through the levee, 11 feet below the crown. Flap gate on the waterside (WS) end. Concrete headwall on the landside (LS) end. Concrete U-shaped headwall on the WS end. [Additional Reference(s): DWR Levee Log, 2002].					
FS Date: 4/3/2014

Concrete headwall on WS toe.

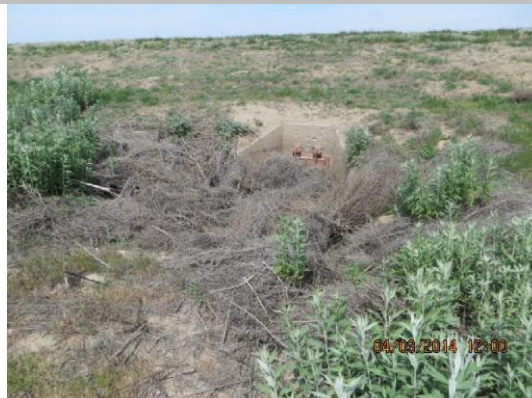
Photo 2 of 3 : UCIP_FA_2019_39538_59857.jpg

Comment Code						
Inspector Comment						
DS_ID:19948						
FS_ID:39538						
EP_NO: N/A						
Repair Type: Non-Urgent						
Crossing Status: Found						
UCIP Comments: 04/03/2014 Appears abandoned and if so should be done properly. Discharge channel is blocked by sand and soil making drain ineffective. Soil buildup at inlet on LS toe. Need to contact owner. (DWR UCIP - W. Wylie)						
FIELD_STRUCT_DESC: 30-inch by 30-inch square reinforced concrete box gravity drainage culvert through the levee, 11 feet below the crown. Flap gate on the waterside (WS) end. Concrete headwall on the landside (LS) end. Concrete U-shaped headwall on the WS end. [Additional Reference(s): DWR Levee Log, 2002].						
FS Date: 4/3/2014

Flapgate on Concrete headwall at WS toe.

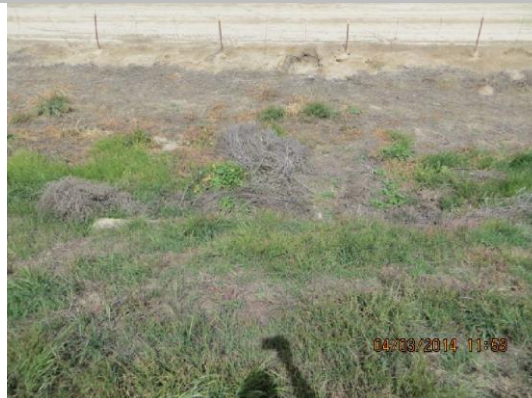
Photo 3 of 3 : UCIP_FA_2019_39538_59856.jpg

Concrete headwall on LS toe.

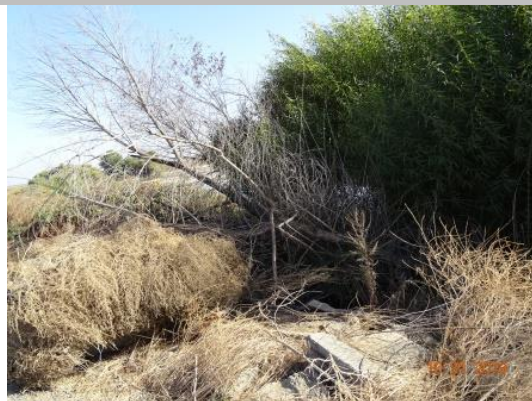
Photo 1 of 2 : FA_2019_NA0010_139_1_20191114_00040.jpg

LM Start	1.91	Rating **	U	Issue No.	1
LM End	1.91	Issue Type +	Ma	Location *	WS
Category	Earthen Levee		GPS Latitude/Longitude		
			Start	End	
Item	Encroachments		36.772943°	36.772943°	
			-120.253511°	-120.253511°	
DWR ID	DWR_NA0010_23_s_2015_1				
Comment Code					
TR : Tree or limb					
Inspector Comment					
There is a downed tree on the waterside slope.

View of fallen tree on the waterside slope. (Fall 2019)

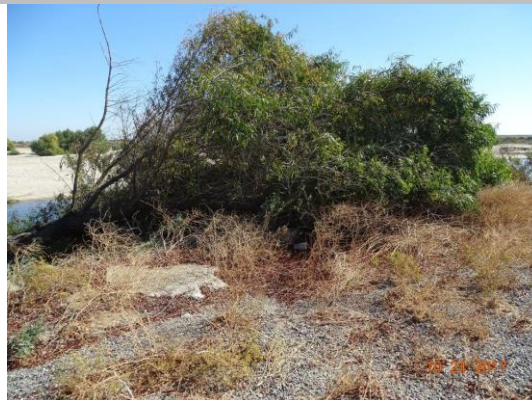
Photo 2 of 2 : FA_2019_NA0010_139_1_20190912_00001.jpg

LM Start	1.91	Rating **	U	Issue No.	1 (cont)	
LM End	1.91	Issue Type +	Ma	Location *	WS	
Category	Earthen Levee			GPS Latitude/Longitude		
				Start		End
Item	Encroachments			36.772943 °	36.772943 °	
				-120.253511 °	-120.253511 °	
DWR ID	DWR_NA0010_23_s_2015_1					
Comment Code						
TR : Tree or limb						
Inspector Comment						
There is a downed tree on the waterside slope.

Looking east at waterside slope.

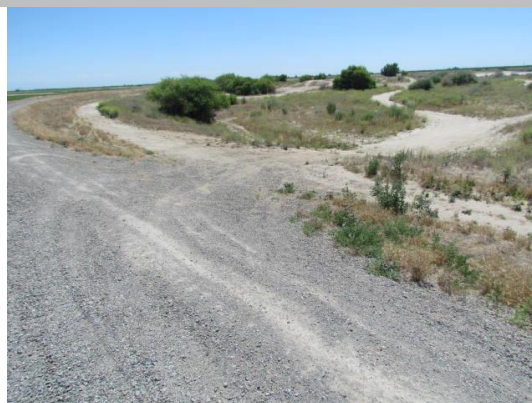
Photo 1 of 1 : FA_2019_NA0010_139_16_20190912_00003.jpg

LM Start	2.12	Rating **	M	Issue No.	16
LM End	2.12	Issue Type +	Ma	Location *	WS
Category	Earthen Levee			GPS Latitude/Longitude	
				Start	End
Item	Slope Stability			36.775507 °	36.775507 °
				-120.251670 °	-120.251672 °
DWR ID	DWR_NA0010_23_s_2013_16				
Comment Code					
S3 : Repair the levee slope damaged by vehicle traffic and prevent access where possible.					
Inspector Comment					
Slope damage is caused by vehicle traffic.

Looking west at one of several damaged slopes cause by vehicle traffic.

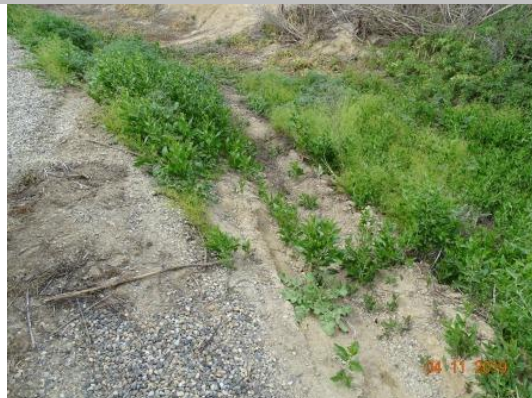
Photo 1 of 2 : FA_2019_NA0010_139_62_20190912_00010.jpg

LM Start	4.85	Rating **	M	Issue No.	62
LM End	4.85	Issue Type +	Ma	Location *	LS
Category	Earthen Levee			GPS Latitude/Longitude	
				Start	End
Item	Slope Stability			36.789489°	36.789489°
				-120.220403°	-120.220403°
DWR ID	DWR_NA0010_23_s_2019_62				
Comment Code					
S3 : Repair the levee slope damaged by vehicle traffic and prevent access where possible.					
Inspector Comment

View of damage to landside slope by vehicle traffic looking downstream. (Spring 2019)

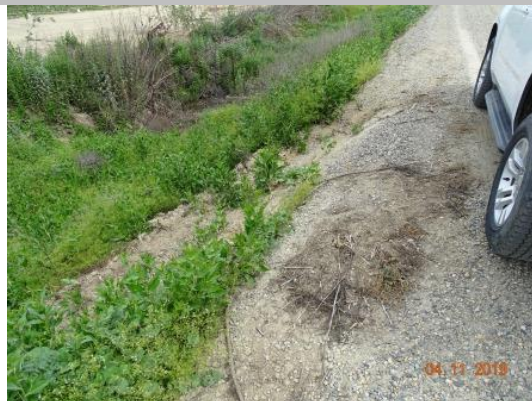
Photo 2 of 2 : FA_2019_NA0010_139_62_20190912_00011.jpg

View of damage to slope looking upstream. (Spring 2019)

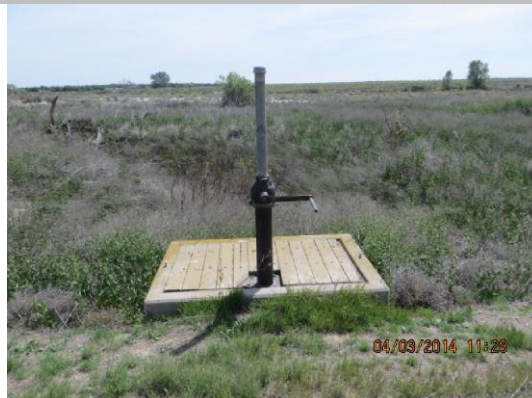
Photo 1 of 3 : UCIP_FA_2019_39540_59848.jpg

LM Start	4.85	Rating **	M	Issue No.	69	
LM End	4.85	Issue Type +	En	Location *		
Category	Supplemental			GPS Latitude/Longitude		
				Start		End
Item	DRAFT DWR UCIP Field Study			36.789550 °		36.789550 °
				-120.220367 °		-120.220367 °
DWR ID	19953					
Comment Code						
Inspector Comment						
DS_ID:19953 FS_ID:39540 EP_NO: N/A Repair Type: Non-Urgent Crossing Status: Found UCIP Comments: 04/03/2014 Heavy vegetation at inlet and outlet--recommend clearing. (DWR UCIP - W. Wylie) FIELD_STRUCT_DESC: 30-inch by 30-inch square reinforced concrete box gravity irrigation culvert through the levee, 10.7 feet below the crown. 4.5-foot by 7-foot concrete riser with slide gate on the waterside (WS) slope. Concrete U-shaped headwall on each end. 15-foot-long cobble revetted inlet channel. [Additional Reference(s): DWR Levee Log, 2002]. FS Date: 4/3/2014

Slide gate in concrete riser on WS shoulder.

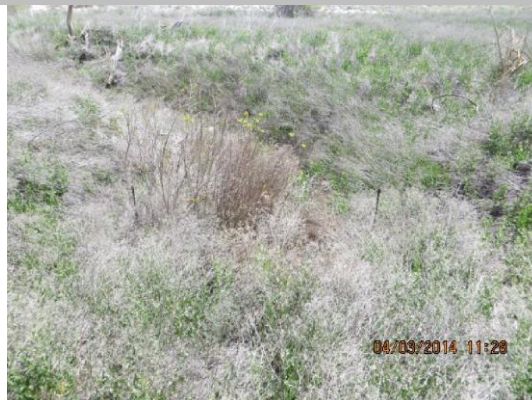
Photo 2 of 3 : UCIP_FA_2019_39540_59847.jpg

LM Start	4.85	Rating **	M	Issue No.	69 (cont)
LM End	4.85	Issue Type +	En	Location *

Heavy vegetation in outlet/channel on WS toe.

Comment Code						
Inspector Comment						
DS_ID:19953						
FS_ID:39540						
EP_NO: N/A						
Repair Type: Non-Urgent						
Crossing Status: Found						
UCIP Comments: 04/03/2014 Heavy vegetation at inlet and outlet--recommend clearing. (DWR UCIP - W. Wylie)						
FIELD_STRUCT_DESC: 30-inch by 30-inch square reinforced concrete box gravity irrigation culvert through the levee, 10.7 feet below the crown. 4.5-foot by 7-foot concrete riser with slide gate on the waterside (WS) slope. Concrete U-shaped headwall on each end. 15-foot-long cobble revetted inlet channel. [Additional Reference(s): DWR Levee Log, 2002].						
FS Date: 4/3/2014

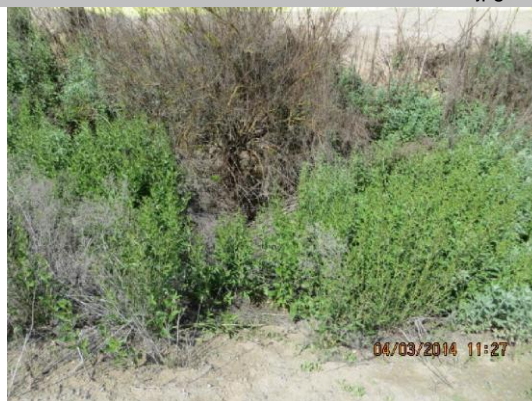
Photo 3 of 3 : UCIP_FA_2019_39540_59849.jpg

Heavy vegetation at concrete inlet on LS toe.

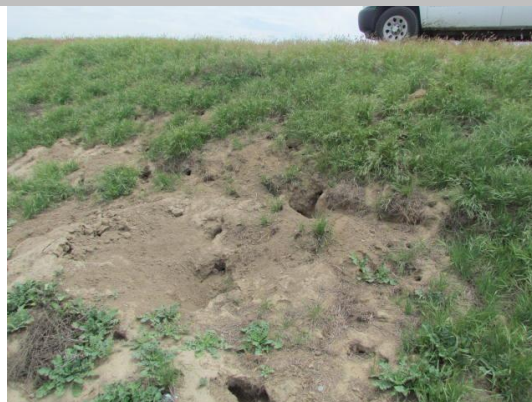
Photo 1 of 1 : FA_2019_NA0010_139_5_20190912_00002.jpg

LM Start	5.68	Rating **	U	Issue No.	5
LM End	5.68	Issue Type +	Ma	Location *	LS
Category	Earthen Levee			GPS Latitude/Longitude	
				Start	End
Item	Animal Control			36.791981°	36.791981°
				-120.206274°	-120.206274°
DWR ID	DWR_NA0010_23_s_2012_5				
Comment Code					
A1 : Exterminate rodents and backfill and compact or grout burrows.					
Inspector Comment					
There are several large rodent holes in this area.

Looking at several rodent holes on landside slope.

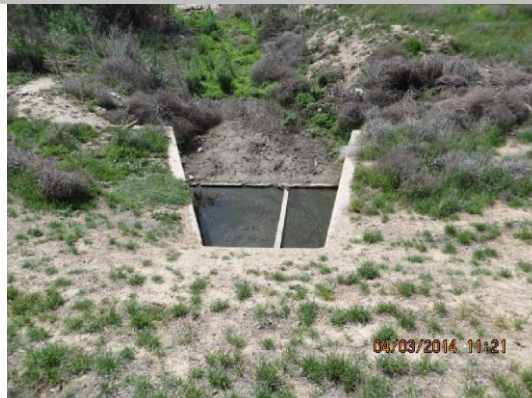
Photo 1 of 3 : UCIP_FA_2019_39542_59830.jpg

Concrete headwall on WS toe.

Comment Code					
Inspector Comment					
DS_ID:19954 FS_ID:39542 EP_NO: N/A Repair Type: Non-Urgent Crossing Status: Found UCIP Comments: 04/03/2014 Dense vegetation limits the inspector's visibility to identify signs of pipe failure (leaks) along the landward slope. Recommend removing vegetation along pipe alignment to conduct proper inspection of structure. (DWR UCIP - W. Wylie) FIELD_STRUCT_DESC: 36-inch by 36-inch square reinforced concrete box gravity drainage culvert through the levee, 9 feet below the crown. Flap gate on the waterside (WS) end. Concrete U-shaped headwall on each end. 5-foot-long cobble revetted outlet channel. [Additional Reference(s): DWR Levee Log, 2002. USACE San Joaquin O&M Manual 601.1, 1967, (HLM 5.71)]. FS Date: 4/3/2014

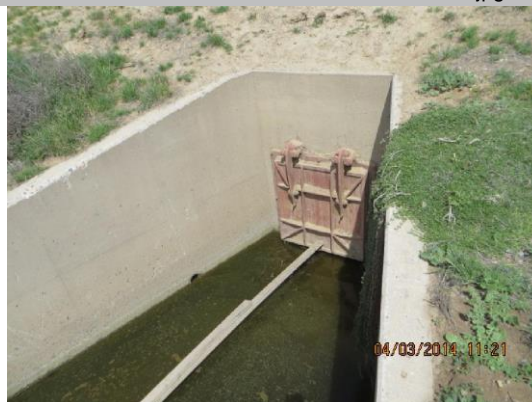
Photo 2 of 3 : UCIP_FA_2019_39542_59829.jpg

LM Start	5.68	Rating **	M	Issue No.	70 (cont)
LM End	5.68	Issue Type +	Ma	Location *

Flapgate on Concrete headwall on WS toe.

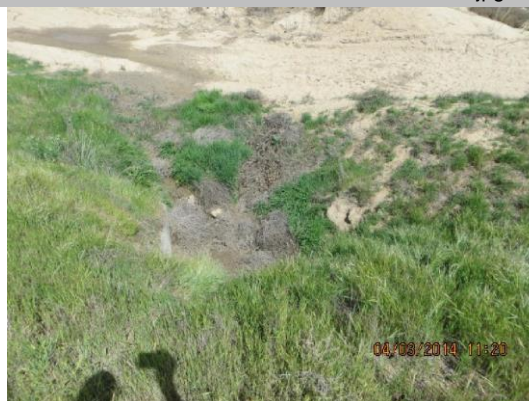
Photo 3 of 3 : UCIP_FA_2019_39542_59831.jpg

Concrete headwall at LS toe.

Comment Code						
Inspector Comment						
DS_ID:19954 FS_ID:39542 EP_NO: N/A Repair Type: Non-Urgent Crossing Status: Found UCIP Comments: 04/03/2014 Dense vegetation limits the inspector's visibility to identify signs of pipe failure (leaks) along the landward slope. Recommend removing vegetation along pipe alignment to conduct proper inspection of structure. (DWR UCIP - W. Wylie) FIELD_STRUCT_DESC: 36-inch by 36-inch square reinforced concrete box gravity drainage culvert through the levee, 9 feet below the crown. Flap gate on the waterside (WS) end. Concrete U-shaped headwall on each end. 5-foot-long cobble revetted outlet channel. [Additional Reference(s): DWR Levee Log, 2002. USACE San Joaquin O&M Manual 601.1, 1967, (HLM 5.71)]. FS Date: 4/3/2014

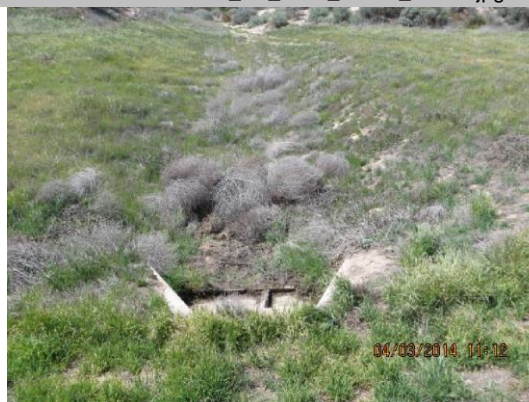
Photo 1 of 3 : UCIP_FA_2019_39543_59826.jpg

LM Start	7.06	Rating **	M	Issue No.	71	
LM End	7.06	Issue Type +	En	Location *		
Category	Supplemental			GPS Latitude/Longitude		
				Start		End
Item	DRAFT DWR UCIP Field Study			36.778783 °	36.778783 °	
				-120.192447 °	-120.192447 °	
DWR ID	19939

Concrete headwall on WS toe.

Comment Code						
Inspector Comment						
DS_ID:19939 FS_ID:39543 EP_NO: N/A Repair Type: Non-Urgent Crossing Status: Found UCIP Comments: 04/03/2014 Dense vegetation limits the inspector's visibility to identify signs of pipe failure (leaks) along the landward slope. Recommend removing vegetation along pipe alignment to conduct proper inspection of structure. (DWR UCIP - W. Wylie) FIELD_STRUCT_DESC: 30-inch by 30-inch square reinforced concrete box gravity drainage culvert through the levee, 8.5 feet below the crown. Flap gate on the waterside (WS) end. Concrete headwall on the landside (LS) end. Concrete U-shaped headwall on the WS end. [Additional Reference(s): DWR Levee Log, 2002]. FS Date: 4/3/2014

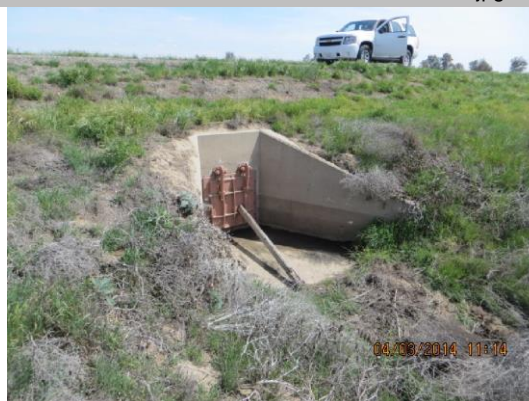
Photo 2 of 3 : UCIP_FA_2019_39543_59828.jpg

Flapgate on Concrete headwall at WS toe.

Comment Code						
Inspector Comment						
DS_ID:19939						
FS_ID:39543						
EP_NO: N/A						
Repair Type: Non-Urgent						
Crossing Status: Found						
UCIP Comments: 04/03/2014 Dense vegetation limits the inspector's visibility to identify signs of pipe failure (leaks) along the landward slope. Recommend removing vegetation along pipe alignment to conduct proper inspection of structure. (DWR UCIP - W. Wylie)						
FIELD_STRUCT_DESC: 30-inch by 30-inch square reinforced concrete box gravity drainage culvert through the levee, 8.5 feet below the crown. Flap gate on the waterside (WS) end. Concrete headwall on the landside (LS) end. Concrete U-shaped headwall on the WS end. [Additional Reference(s): DWR Levee Log, 2002].						
FS Date: 4/3/2014

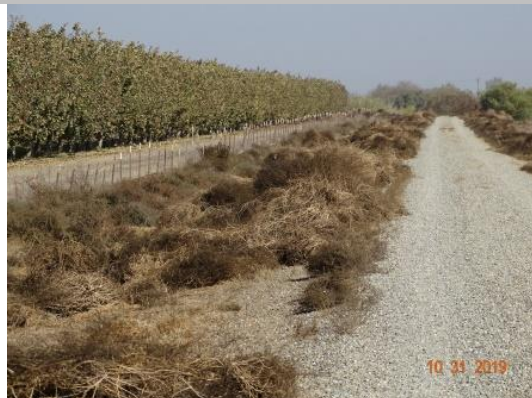
Photo 1 of 1 : FA_2019_NA0010_139_42_20191114_00041.jpg

LM Start	7.42	Rating **	U	Issue No.	42
LM End	8.26	Issue Type +	Ma	Location *	LS
Category	Earthen Levee			GPS Latitude/Longitude	
				Start	End
Item	Vegetation			36.780736°	36.791803°
				-120.187219°	-120.181770°
DWR ID	DWR_NA0010_23_f_2019_42				
Comment Code					
V1 : Control annual grass and weeds on the levee slopes and easements.					
Inspector Comment

Looking upstream along the landside slope. (Fall 2019)

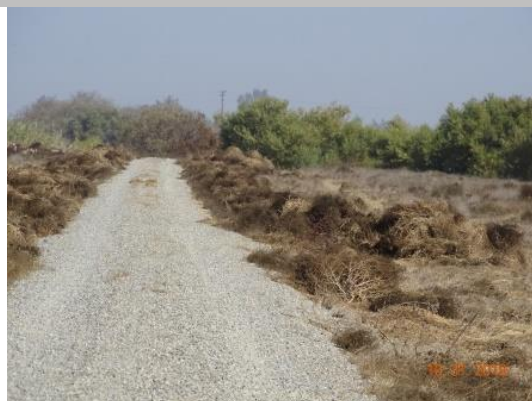
Photo 1 of 1 : FA_2019_NA0010_139_43_20191114_00042.jpg

LM Start	7.42	Rating **	U	Issue No.	43
LM End	8.25	Issue Type +	Ma	Location *	WS
Category	Earthen Levee			GPS Latitude/Longitude	
				Start	End
Item	Vegetation			36.780795°	36.791668°
				-120.187163°	-120.181844°
DWR ID	DWR_NA0010_23_f_2019_43				
Comment Code					
V1 : Control annual grass and weeds on the levee slopes and easements.					
Inspector Comment

View of the waterside slope looking upstream. (Fall 2019)

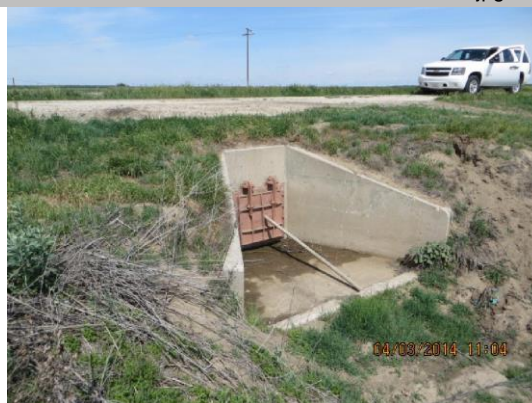
Photo 1 of 3 : UCIP_FA_2019_39544_59823.jpg

Flapgate on WS toe.

Comment Code					
Inspector Comment					
DS_ID:19940 FS_ID:39544 EP_NO: N/A Repair Type: Non-Urgent Crossing Status: Found UCIP Comments: 04/03/2014 Some sediment buildup at inlet at LS toe. Also dense vegetation limits the inspector's visibility to identify signs of pipe failure (leaks) along the landward slope. Recommend removing vegetation along pipe alignment to conduct proper inspection of structure. (DWR UCIP - W. Wylie) FIELD_STRUCT_DESC: 30-inch by 30-inch square reinforced concrete box gravity drainage culvert through the levee, 5.2 feet below the crown. Flap gate on the waterside (WS) end. Concrete headwall on the landside (LS) end. Concrete U-shaped headwall on the WS end. [Additional Reference(s): DWR Levee Log, 2002. USACE San Joaquin O&M Manual 601.1, 1967, (HLM 8.33)]. FS Date: 4/3/2014

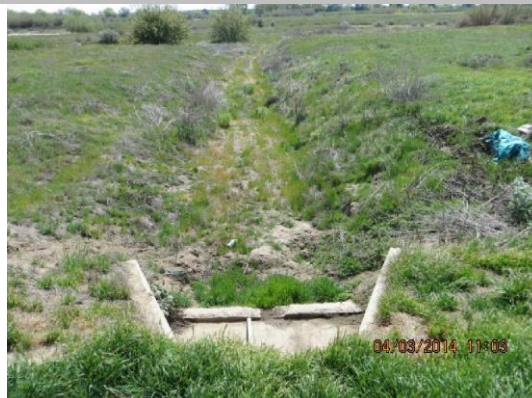
Photo 2 of 3 : UCIP_FA_2019_39544_59821.jpg

cocnrete headwall at drainage ditch on WS toe.

Comment Code						
Inspector Comment						
DS_ID:19940 FS_ID:39544 EP_NO: N/A Repair Type: Non-Urgent Crossing Status: Found UCIP Comments: 04/03/2014 Some sediment buildup at inlet at LS toe. Also dense vegetation limits the inspector's visibility to identify signs of pipe failure (leaks) along the landward slope. Recommend removing vegetation along pipe alignment to conduct proper inspection of structure. (DWR UCIP - W. Wylie) FIELD_STRUCT_DESC: 30-inch by 30-inch square reinforced concrete box gravity drainage culvert through the levee, 5.2 feet below the crown. Flap gate on the waterside (WS) end. Concrete headwall on the landside (LS) end. Concrete U-shaped headwall on the WS end. [Additional Reference(s): DWR Levee Log, 2002. USACE San Joaquin O&M Manual 601.1, 1967, (HLM 8.33)]. FS Date: 4/3/2014

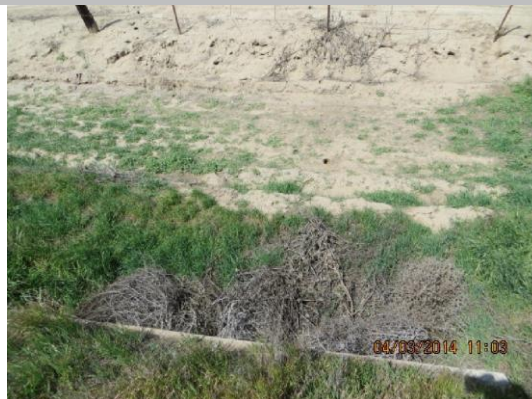
Photo 3 of 3 : UCIP_FA_2019_39544_59822.jpg

LM Start	8.32	Rating **	M	Issue No.	72 (cont)
LM End	8.32	Issue Type +	Ma	Location *

Concrete headwall on LS toe.

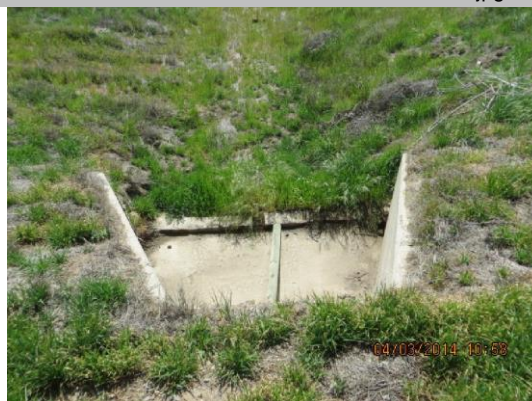
Photo 1 of 3 : UCIP_FA_2019_39545_59817.jpg

Concrete headwall on WS toe.

Comment Code						
Inspector Comment						
DS_ID:19941						
FS_ID:39545						
EP_NO: N/A						
Repair Type: Non-Urgent						
Crossing Status: Found						
UCIP Comments: 04/03/2014 Dense vegetation limits the inspector's visibility to identify signs of pipe failure (leaks) along the landward slope. Recommend removing vegetation along pipe alignment to conduct proper inspection of structure. (DWR UCIP - W. Wylie)						
FIELD_STRUCT_DESC: 30-inch by 30-inch square reinforced concrete box gravity drainage culvert through the levee, 5.6 feet below the crown. Flap gate on the waterside (WS) end. Concrete headwall on the landside (LS) end. Concrete U-shaped headwall on the WS end.						
[Additional Reference(s): DWR Levee Log, 2002. USACE San Joaquin O&M Manual 601.1, 1967, (HLM 8.54)].						
FS Date: 4/3/2014

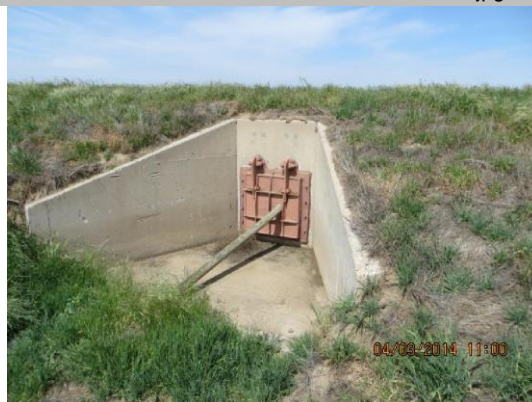
Photo 2 of 3 : UCIP_FA_2019_39545_59819.jpg

LM Start	8.52	Rating **	M	Issue No.	73 (cont)
LM End	8.52	Issue Type +	Ma	Location *

Flapgate on Concrete headwall at WS toe.

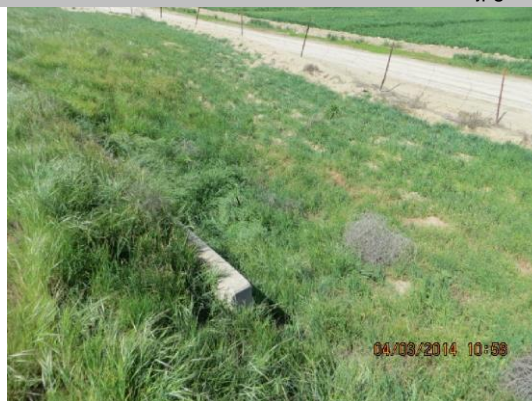
Photo 3 of 3 : UCIP_FA_2019_39545_59818.jpg

Concrete headwall on LS toe.

Comment Code						
Inspector Comment						
DS_ID:19941						
FS_ID:39545						
EP_NO: N/A						
Repair Type: Non-Urgent						
Crossing Status: Found						
UCIP Comments: 04/03/2014 Dense vegetation limits the inspector's visibility to identify signs of pipe failure (leaks) along the landward slope. Recommend removing vegetation along pipe alignment to conduct proper inspection of structure. (DWR UCIP - W. Wylie)						
FIELD_STRUCT_DESC: 30-inch by 30-inch square reinforced concrete box gravity drainage culvert through the levee, 5.6 feet below the crown. Flap gate on the waterside (WS) end. Concrete headwall on the landside (LS) end. Concrete U-shaped headwall on the WS end.						
[Additional Reference(s): DWR Levee Log, 2002. USACE San Joaquin O&M Manual 601.1, 1967, (HLM 8.54)].						
FS Date: 4/3/2014

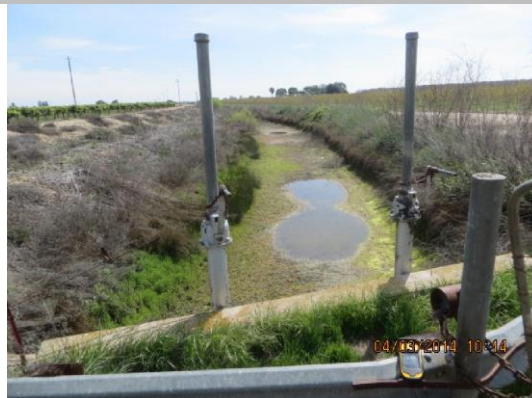
Photo 1 of 3 : UCIP_FA_2019_53192_59810.jpg

LM Start	9.75	Rating **	M	Issue No.	74 (cont)
LM End	9.75	Issue Type +	En	Location *

Slide gate actuator visible on WS shoulder with concrete headwall.

Comment Code					
Inspector Comment					
DS_ID:19943 FS_ID:53192 EP_NO: N/A Repair Type: Non-Urgent Crossing Status: Found UCIP Comments: 11/01/2018 Limited access to both LS and WS; assumed slide gates are still non-functional; Crossing has been downgraded from Urgent to Non-Urgent due to re-classification of damage slide gates. (O. Magana - DWR UCIP)07/20/2016 No change--same as previous inspection. (DWR UCIP - omagana)04/03/2014 Slide gate not functional. Slide gate channels heavily corroded (exfoliated) and likely impact functionality/structural integrity of gate. (DWR UCIP - wwylie) FIELD_STRUCT_DESC: [Gravelly Ford Canal Irrigation Structure] 1 of 2: 48-inch by 63-inch reinforced concrete box gravity irrigation culvert through the levee, 10 feet below the crown. Concrete U-shaped headwall on each end. Gear pedestal slide gate with wall bracket on the waterside (WS) headwall. 10-foot-long cobble revetted outlet channel. Guardrail on each shoulder. Slide gates on the WS. [Additional Reference(s): DWR Levee Log, 2002. USACE San Joaquin O&M Manual 601.1, 1967, (HLM 9.76)]. FS Date: 11/1/2018 12:50:00 PM

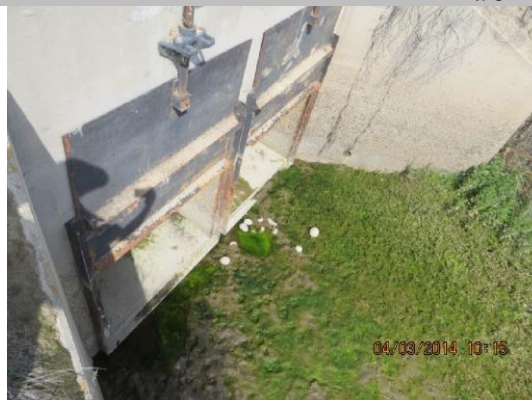
Photo 2 of 3 : UCIP_FA_2019_53192_59809.jpg

Slide gate on concrete headwall at WS toe.

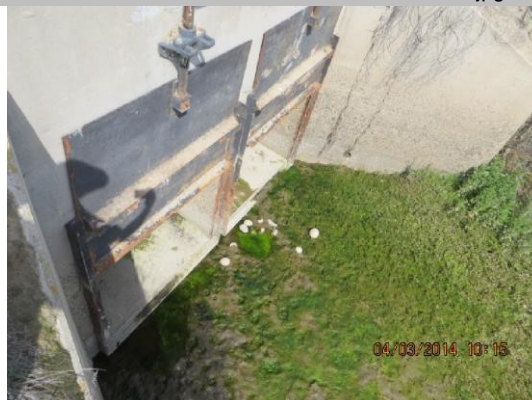
Photo 2 of 3 : UCIP_FA_2019_53193_59801.jpg

Slide gates on WS toe.

Comment Code					
Inspector Comment					
DS_ID:19980 FS_ID:53193 EP_NO: N/A Repair Type: Non-Urgent Crossing Status: Found UCIP Comments: 11/01/2018 Limited access to both LS and WS; assumed slide gates are still non-functional; Crossing has been downgraded from Urgent to Non-Urgent due to re-classification of damage slide gates. (O. Magana - DWR UCIP)07/20/2016 No change--same as previous inspection. (DWR UCIP - omagana)04/03/2014 Slide gate not functional. Slide gate channels heavily corroded (exfoliated) and likely impact functionality/structural integrity of gate. (DWR UCIP - wwylie) FIELD_STRUCT_DESC: [Gravelly Ford Canal Irrigation Structure] 2 of 2: 48-inch by 63-inch reinforced concrete box gravity irrigation culvert through the levee, 10 feet below the crown. Concrete U-shaped headwall on each end. Gear pedestal slide gate with wall bracket on the waterside (WS) headwall. 10-foot-long cobble revetted outlet channel. Guardrail on each shoulder. [Additional Reference(s): DWR Levee Log, 2002]. FS Date: 11/1/2018 12:51:00 PM

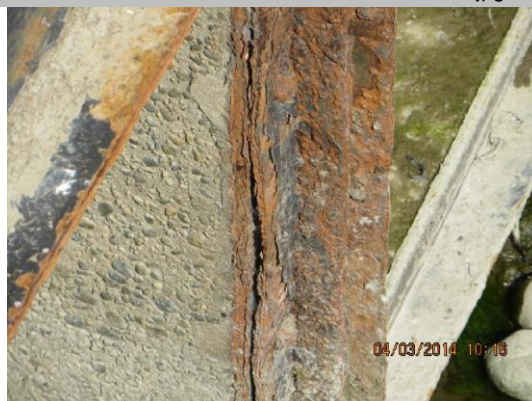
Photo 3 of 3 : UCIP_FA_2019_53193_59800.jpg

Slide gate tracks show heavy corrosion impacting actuation of slide gate.

Comment Code						
Inspector Comment						
DS_ID:19980 FS_ID:53193 EP_NO: N/A Repair Type: Non-Urgent Crossing Status: Found UCIP Comments: 11/01/2018 Limited access to both LS and WS; assumed slide gates are still non-functional; Crossing has been downgraded from Urgent to Non-Urgent due to re-classification of damage slide gates. (O. Magana - DWR UCIP)07/20/2016 No change--same as previous inspection. (DWR UCIP - omagana)04/03/2014 Slide gate not functional. Slide gate channels heavily corroded (exfoliated) and likely impact functionality/structural integrity of gate. (DWR UCIP - wwylie) FIELD_STRUCT_DESC: [Gravelly Ford Canal Irrigation Structure] 2 of 2: 48-inch by 63-inch reinforced concrete box gravity irrigation culvert through the levee, 10 feet below the crown. Concrete U-shaped headwall on each end. Gear pedestal slide gate with wall bracket on the waterside (WS) headwall. 10-foot-long cobble revetted outlet channel. Guardrail on each shoulder. [Additional Reference(s): DWR Levee Log, 2002]. FS Date: 11/1/2018 12:51:00 PM

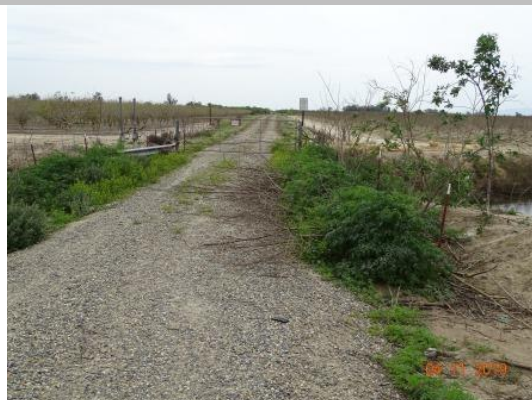
Photo 1 of 3 : FA_2019_NA0010_139_58_20190912_00007.jpg

LM Start	9.79	Rating **	M	Issue No.	58
LM End	9.81	Issue Type +	Ma	Location *	LS
Category	Earthen Levee			GPS Latitude/Longitude	
				Start	End
Item	Trim / Thin Trees			36.808317 °	36.808553 °
				-120.168820 °	-120.168827 °
DWR ID	DWR_NA0010_23_f_2018_58				
Comment Code					
T2 : Thin trees to allow visibility of the ground and room to flood fight.					
Inspector Comment					
Woody vegetation is partially blocking crown and landside slope.

View of woody vegetation on landside shoulder partially blocking access across crown. (Spring 2019)

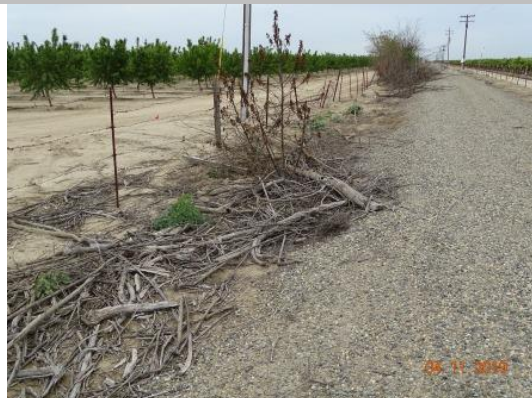
Photo 2 of 3 : FA_2019_NA0010_139_58_20190912_00008.jpg

LM Start	9.79	Rating **	M	Issue No.	58 (cont)	
LM End	9.81	Issue Type +	Ma	Location *	LS	
Category	Earthen Levee			GPS Latitude/Longitude		
				Start		End
Item	Trim / Thin Trees			36.808317 °		36.808553 °
				-120.168820 °		-120.168827 °
DWR ID	DWR_NA0010_23_f_2018_58					
Comment Code						
T2 : Thin trees to allow visibility of the ground and room to flood fight.						
Inspector Comment						
Woody vegetation is partially blocking crown and landside slope.

View of woody vegetation left on landside slope and toe. (Spring 2019)

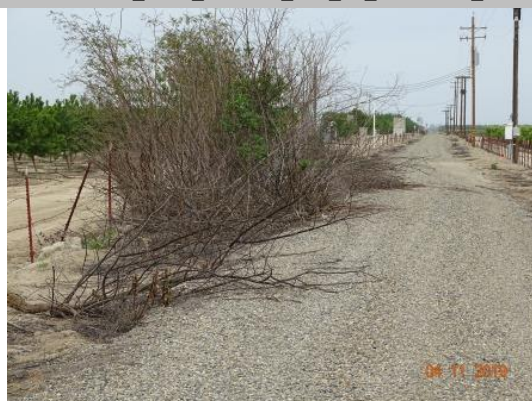
Photo 3 of 3 : FA_2019_NA0010_139_58_20190912_00009.jpg

Woody vegetation on landside toe obstructing landside of crown. (Spring 2019)

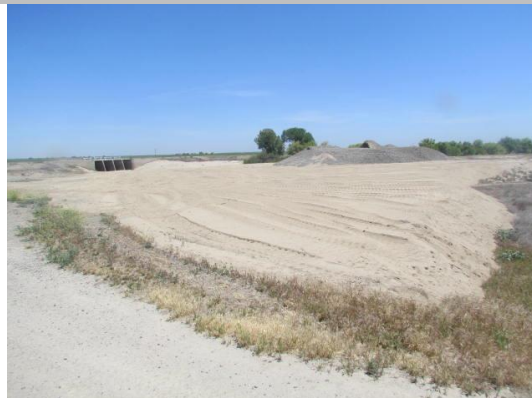
Photo 1 of 2 : FA_2019_NA0010_140_47_20190912_00009.jpg

LM Start	0.06	Rating **	M	Issue No.	47
LM End	0.06	Issue Type +	En	Location *	WS
Category	Earthen Levee			GPS Latitude/Longitude	
				Start	End
Item	Encroachments			36.772328 °	36.772328 °
				-120.285117 °	-120.285117 °
DWR ID	DWR_NA0010_24_s_2014_47				
Comment Code					
MA : Material					
Inspector Comment					
The District constructed a berm on waterside slope. The berm is being used for staging of earthen material.

Looking northeast at berm on waterward slope.

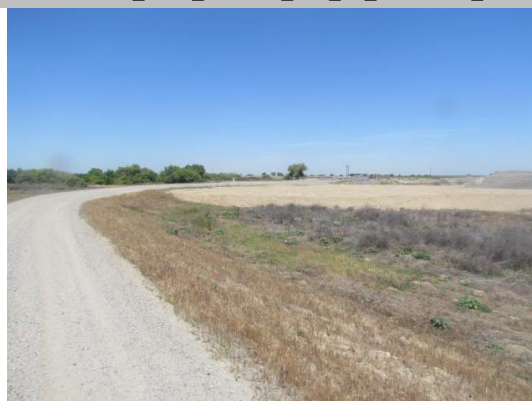
Photo 2 of 2 : FA_2019_NA0010_140_47_20190912_00010.jpg

Looking north at berm on waterward slope.

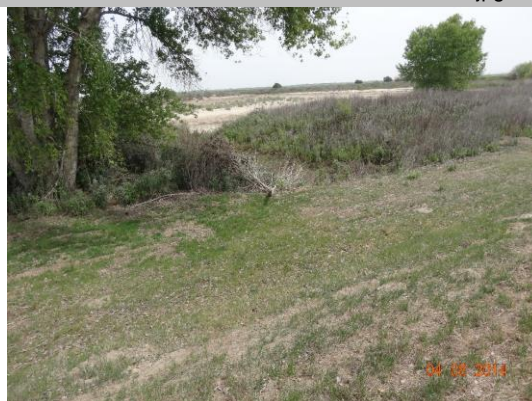
Photo 1 of 3 : UCIP_FA_2019_33264_60059.jpg

Comment Code						
Inspector Comment						
DS_ID:19955						
FS_ID:33264						
EP_NO: N/A						
Repair Type: Non-Urgent						
Crossing Status: Found						
UCIP Comments: 04/08/2014 No access available to confirm condition of landward side headwall. Recommend clearing debris along fence.						
Surface erosion near concrete headwall on landward side was present.						
(DWR UCIP - O. Magana)						
FIELD_STRUCT_DESC: 30-inch by 30-inch square reinforced concrete box gravity drainage culvert through the levee, 13.5 feet below the crown. Flap gate on the waterside (WS) end. Concrete headwall on each end. [Additional Reference(s): DWR Levee Log, 2002].						
FS Date: 4/8/2014

View of waterward side.

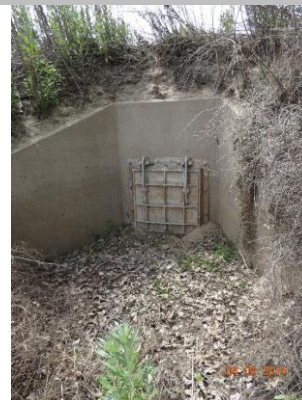
Photo 2 of 3 : UCIP_FA_2019_33264_60057.jpg

Square gate visible on waterward side.

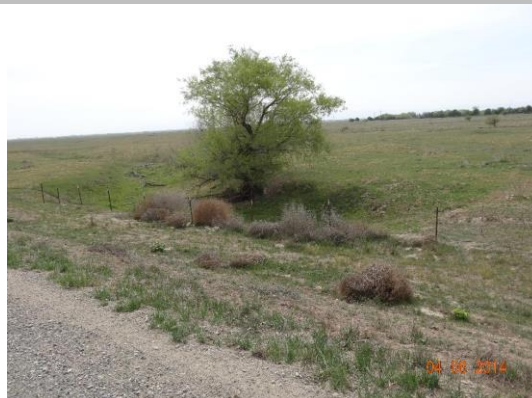
Photo 3 of 3 : UCIP_FA_2019_33264_60058.jpg

View of landward side.

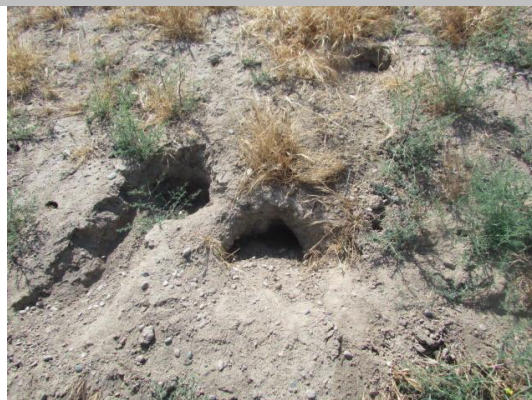
Photo 1 of 1 : FA_2019_NA0010_140_6_20190912_00001.jpg

LM Start	0.82	Rating **	M	Issue No.	6
LM End	0.84	Issue Type +	Ma	Location *	LS
Category	Earthen Levee			GPS Latitude/Longitude	
				Start	End
Item	Animal Control			36.766775 °	36.766962 °
				-120.278757 °	-120.278602 °
DWR ID	DWR_NA0010_24_s_2013_6				
Comment Code					
A1 : Exterminate rodents and backfill and compact or grout burrows.					
Inspector Comment					
There are several rodent holes identified within this section.

Looking at several rodent holes on landward slope.

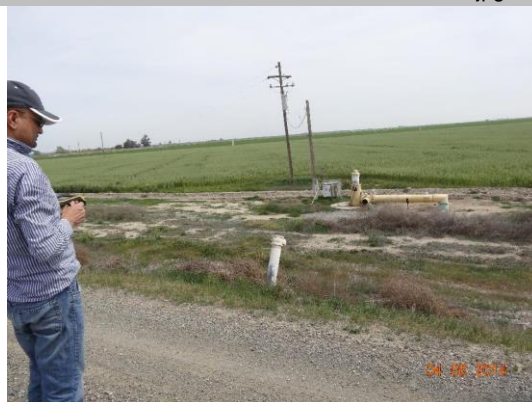
Photo 1 of 2 : UCIP_FA_2019_33265_60065.jpg

Comment Code					
Inspector Comment					
DS_ID:19961					
FS_ID:33265					
EP_NO: 13735					
Repair Type: Non-Urgent					
Crossing Status: Found					
UCIP Comments: 04/08/2014 Unable to determine status of crossing. Need to contact owner to determine status of crossing. (DWR UCIP - O. Magana)					
FIELD_STRUCT_DESC: 24-inch coated steel drainage discharge pipe through the levee, 2 feet below the crown. Crown roadway has been padded 1 foot. Steel cutoff wall around the pipe at the centerline of the levee. Pump on the landside (LS). Siphon breaker on the apex of the pipe on the LS shoulder. Galvanized siphon vent pipe on the LS shoulder. (Plans to install two 24-inch steel discharge pipelines through the levee to dispose of seepage water collected in farm sumps Nos. 8 and 12 authorized under Permit No. 13735, 1983 - Rio Seco Farm).					
[Additional Reference(s): DWR Levee Log, 2002].					
FS Date: 4/8/2014

View of landward side.

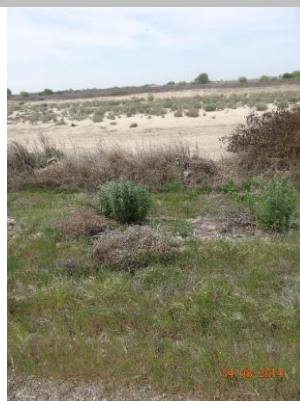
Photo 2 of 2 : UCIP_FA_2019_33265_60064.jpg

View of waterward side.

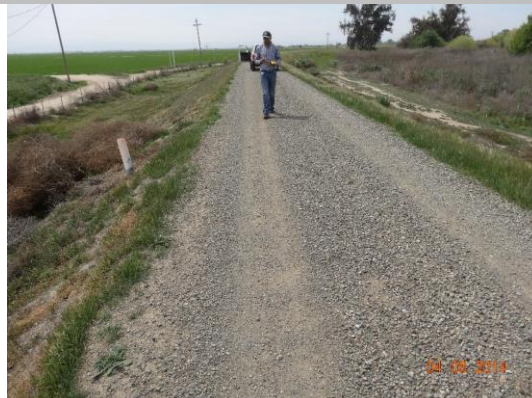
Photo 1 of 3 : UCIP_FA_2019_33266_60069.jpg

Comment Code						
Inspector Comment						
DS_ID:19962 FS_ID:33266 EP_NO: 13085 Repair Type: Non-Urgent Crossing Status: Indicator Found UCIP Comments: 04/08/2014 Need to contact owner to determine status. (DWR UCIP - O. Magana) FIELD_STRUCT_DESC: 20-inch coated steel gravity drainage pipe through the levee, 2 feet below the crown. Pipe encased in concrete through the levee crown. Steel cutoff wall around the pipe at each shoulder. Siphon breaker installed on the apex of the pipe on the landside (LS) shoulder. Vent pipe on LS shoulder. Rock riprap on the waterside (WS) slope. (Plans to construct a new discharge structure and to rehabilitate one existing diversion structure to return intercepted seepage to the San Joaquin River authorized under Permit No. 13085, 1981 - Diener, Dry River Farms). [Additional Reference(s): DWR Levee Log, 2002]. FS Date: 4/8/2014

Overview of levee crown at crossing.

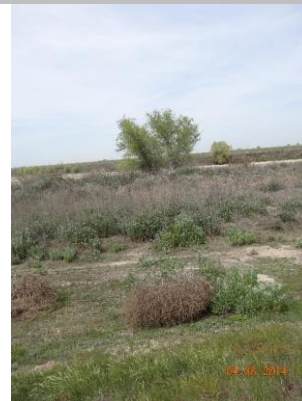
Photo 2 of 3 : UCIP_FA_2019_33266_60070.jpg

View of waterward side.

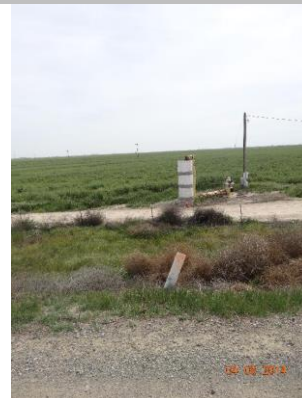
Photo 3 of 3 : UCIP_FA_2019_33266_60071.jpg

View of landward side.

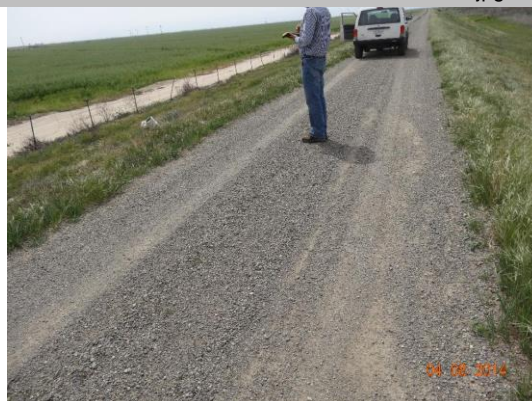
Photo 1 of 3 : UCIP_FA_2019_33267_60075.jpg

Comment Code					
Inspector Comment					
DS_ID:19963 FS_ID:33267 EP_NO: 13735 Repair Type: Non-Urgent Crossing Status: Found UCIP Comments: 04/08/2014 Unable to confirm status of crossing. (DWR UCIP - O. Magana) FIELD_STRUCT_DESC: 24-inch coated steel drainage discharge pipe through the levee, 2 feet below the crown. Crown roadway has been padded 1 foot. Steel cutoff wall around the pipe at the centerline of the levee. Pump on the landside (LS). Siphon breaker on the apex of the pipe on the LS shoulder. Galvanized siphon vent pipe on the LS shoulder. (Plans to install two 24-inch steel discharge pipelines through the levee to dispose of seepage water collected in farm sumps Nos. 8 and 12 authorized under Permit No. 13735, 1983 - Rio Seco Farm). [Additional Reference(s): DWR Levee Log, 2002]. FS Date: 4/8/2014

Overview of levee crown at crossing.

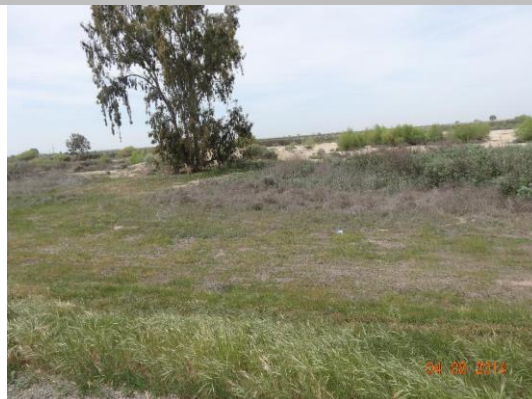
Photo 2 of 3 : UCIP_FA_2019_33267_60076.jpg

View of waterward side.

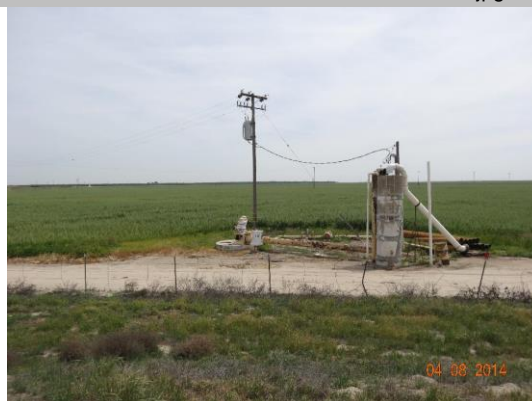
Photo 3 of 3 : UCIP_FA_2019_33267_60077.jpg

View of landward side.

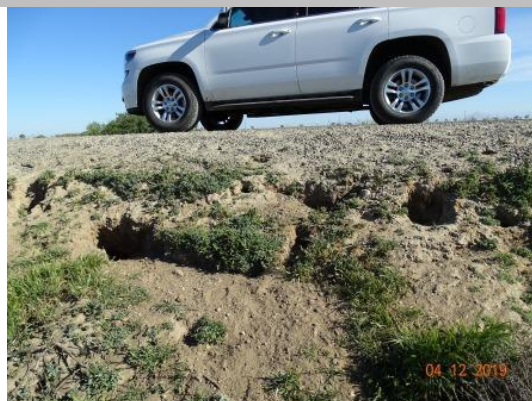
Photo 1 of 1 : FA_2019_NA0010_140_51_20190912_00011.jpg

LM Start	3.05	Rating **	U	Issue No.	51
LM End	3.10	Issue Type +	Ma	Location *	LS
Category	Earthen Levee			GPS Latitude/Longitude	
				Start	End
Item	Animal Control			36.770146°	36.769966°
				-120.245703°	-120.244853°
DWR ID	DWR_NA0010_24_s_2019_51				
Comment Code					
A3 : No rodents visible, but rodent burrows visible; need to backfill and compact or grout burrows.					
Inspector Comment

View of rodent holes in landside slope. (Spring 2019)

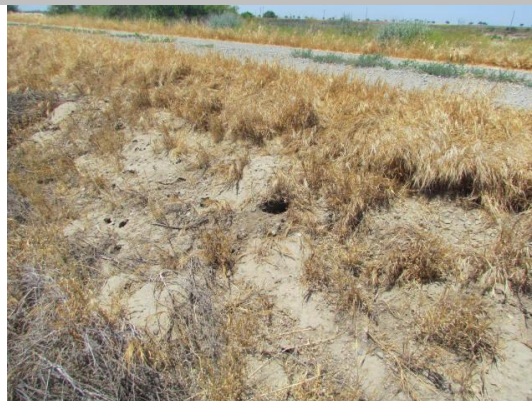
Photo 1 of 1 : FA_2019_NA0010_140_7_20190912_00002.jpg

LM Start	3.46	Rating **	M	Issue No.	7
LM End	3.46	Issue Type +	Ma	Location *	LS
Category	Earthen Levee			GPS Latitude/Longitude	
				Start	End
Item	Animal Control			36.769345 °	36.769345 °
				-120.238370 °	-120.238370 °
DWR ID	DWR_NA0010_24_s_2012_7				
Comment Code					
A3 : No rodents visible, but rodent burrows visible; need to backfill and compact or grout burrows.					
Inspector Comment					
There are several rodent holes on the landside slope.

Looking east at one of several rodent holes on landward slope.

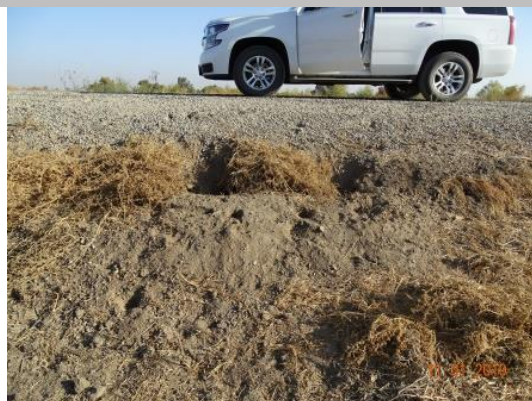
Photo 1 of 1 : FA_2019_NA0010_140_28_20191114_00033.jpg

LM Start	3.56	Rating **	M	Issue No.	28							
LM End	3.56	Issue Type +	Ma	Location *	LS							
Category	Earthen Levee		GPS Latitude/Longitude									
			Start	End								
Item	Animal Control		36.768700 °	36.768700 °								
			-120.236668 °	-120.236668 °								
DWR ID	DWR_NA0010_24_f_2019_28											
Comment Code												
A3 : No rodents visible, but rodent burrows visible; need to backfill and compact or grout burrows.												
Inspector Comment

View of rodent burrows in the landside slope. (Fall 2019)

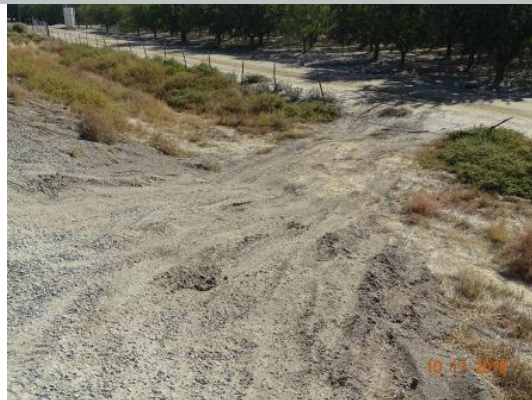
Photo 1 of 1 : FA_2019_NA0010_140_36_20190912_00008.jpg

LM Start	3.77	Rating **	M	Issue No.	36
LM End	3.77	Issue Type +	Ma	Location *	LS
Category	Earthen Levee			GPS Latitude/Longitude	
				Start	End
Item	Slope Stability			36.767784 °	36.767784 °
				-120.233252 °	-120.233252 °
DWR ID	DWR_NA0010_24_f_2018_36				
Comment Code					
S3 : Repair the levee slope damaged by vehicle traffic and prevent access where possible.					
Inspector Comment					
There is damage to the levee slope from vehicle traffic. The landowner appears to have removed a section of fencing to allow access at this location.

View of damage to slope from vehicle traffic. (Fall 2018)

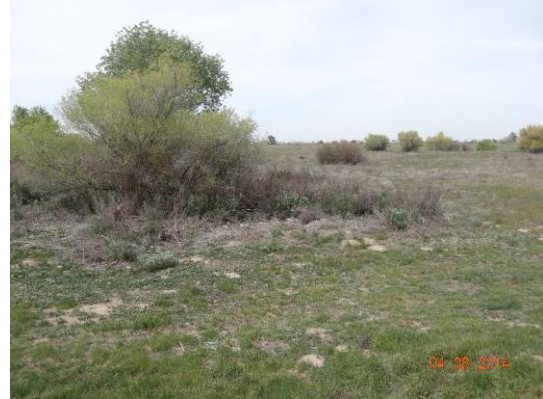
Photo 1 of 3 : UCIP_FA_2019_36849_67237.jpg

Comment Code					
Inspector Comment					
DS_ID:19964 FS_ID:36849 EP_NO: N/A Repair Type: Non-Urgent Crossing Status: Found UCIP Comments: 04/08/2014 Unable to confirm crossing alignment and appurtenances associated with this crossing. Multiple stand pipes visible on landward side. Need to contact owner to determine status of crossing and alignment. (DWR UCIP - O. Magana) FIELD_STRUCT_DESC: 30-inch by 30-inch square reinforced concrete box drainage discharge culvert through the levee, 12.5 feet below the crown. Pump on the landside (LS). Concrete riser with slide gate on the waterside (WS) slope. Screw gate on the LS shoulder. (Plans to construct a new discharge structure and to rehabilitate one existing diversion structure to return intercepted seepage to the San Joaquin River authorized under Permit No. 13085, 1981 - Diener, Dry River Farms). [Additional Reference(s): DWR Levee Log, 2002]. FS Date: 4/8/2014

View of waterward side.

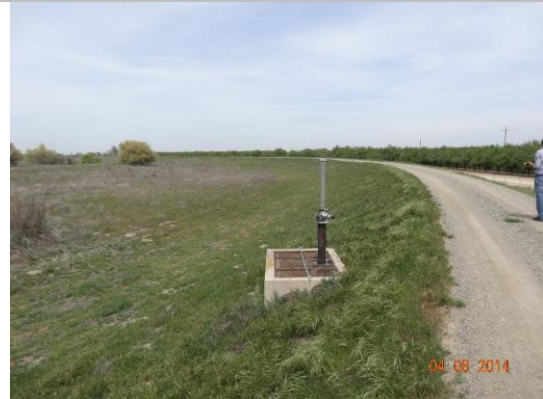
Photo 2 of 3 : UCIP_FA_2019_36849_67236.jpg

Slide gate inside concrete box located on waterward side.

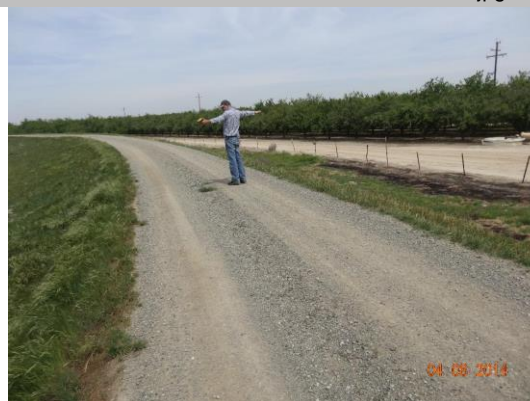
Photo 3 of 3 : UCIP_FA_2019_36849_67235.jpg

Overview of levee at crossing.

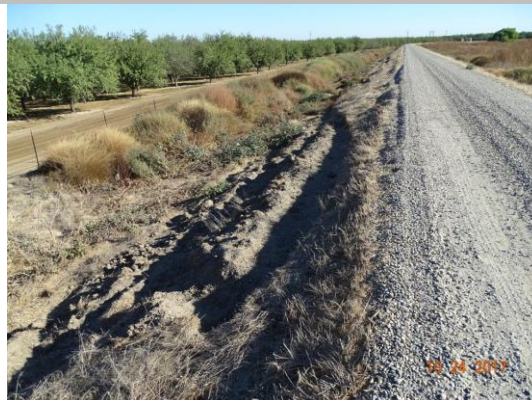
Photo 1 of 1 : FA_2019_NA0010_140_17_20190912_00003.jpg

LM Start	4.27	Rating **	M	Issue No.	17
LM End	4.27	Issue Type +	Ma	Location *	LS
Category	Earthen Levee			GPS Latitude/Longitude	
				Start	End
Item	Slope Stability			36.772003°	36.772003°
				-120.230075°	-120.230075°
DWR ID	DWR_NA0010_24_f_2017_17				
Comment Code					
S3 : Repair the levee slope damaged by vehicle traffic and prevent access where possible.					
Inspector Comment

Looking southeast at the landside slope.

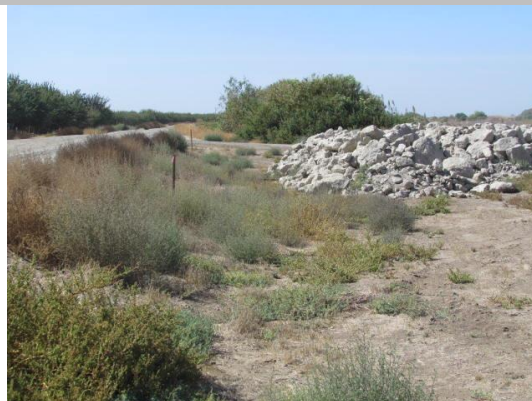
Photo 1 of 2 : FA_2019_NA0010_140_266_20190912_00012.jpg

LM Start	5.30	Rating **	M	Issue No.	266
LM End	5.30	Issue Type +	En	Location *	WS
Category	Earthen Levee			GPS Latitude/Longitude	
				Start	End
Item	Encroachments			36.781960 °	36.781960 °
				-120.224496 °	-120.224496 °
DWR ID	DWR_NA0010_24_s_2015_266				
Comment Code					
MA : Material					
Inspector Comment					
Rocks are stockpiled near the waterside toe.

Looking at rock stockpile on waterward berm. Fall 2015

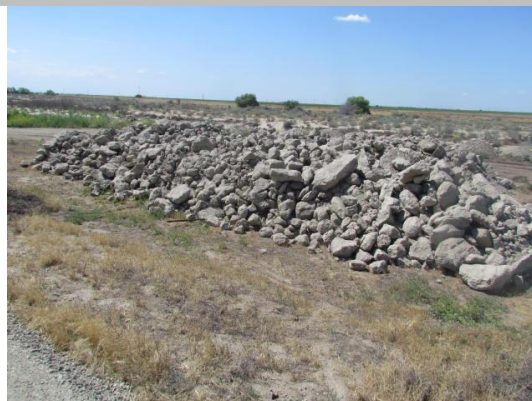
Photo 2 of 2 : FA_2019_NA0010_140_266_20190912_00013.jpg

Looking north at rock pile on waterward berm.

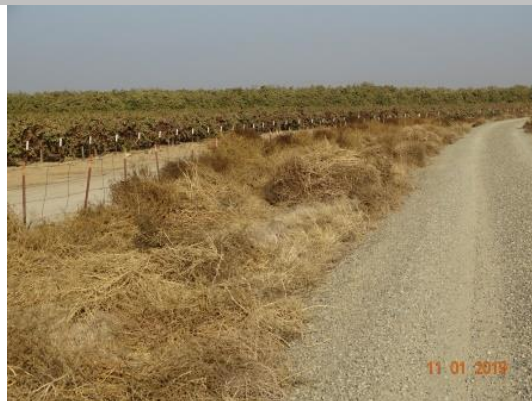
Photo 1 of 1 : FA_2019_NA0010_140_21_20191114_00035.jpg

LM Start	6.67	Rating **	U	Issue No.	21
LM End	7.05	Issue Type +	Ma	Location *	LS
Category	Earthen Levee		GPS Latitude/Longitude		
			Start	End	
Item	Vegetation		36.787329°	36.782295°	
			-120.204978°	-120.202454°	
DWR ID	DWR_NA0010_24_f_2019_21				
Comment Code					
V1 : Control annual grass and weeds on the levee slopes and easements.					
Inspector Comment

View of the landside slope looking downstream. (Fall 2019)

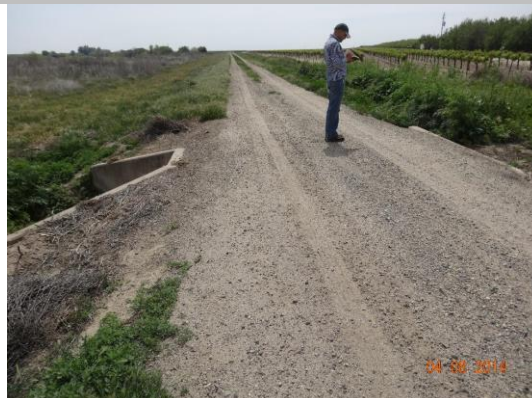
Photo 1 of 3 : UCIP_FA_2019_50056_60105.jpg

Comment Code					
Inspector Comment					
DS_ID:19957 FS_ID:50056 EP_NO: N/A Repair Type: Non-Urgent Crossing Status: Found UCIP Comments: 7/20/2016 same as previous inspection. Crossing has been downgraded from Urgent to Non-Urgent PVC does not prevent WS flap gate from closing. (DWR UCIP - omagana)4/08/2014 Unauthorized PVC pipe through existng crossing. PVC distorted inside--Need to contact owner to correct issue. If crossing was allowed need to contact owner for permit number issue for crossing variance. (DWR UCIP - omagana) FIELD_STRUCT_DESC: 24-inch corrugated metal gravity drainage pipe through the levee, 3.6 feet below the crown. Flap gate on the waterside (WS) end. Concrete headwall on the landside (LS) end. Concrete U-shaped headwall on the WS end. [Additional Reference(s): DWR Levee Log, 2002]. FS Date: 7/20/2016

Overview of levee crown at crossing.

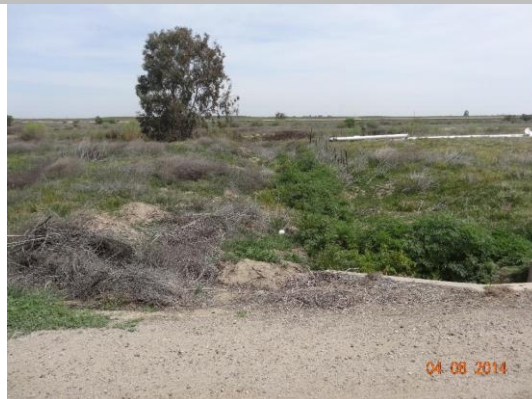
Photo 2 of 3 : UCIP_FA_2019_50056_60107.jpg

View of WS--debris (pipe sections) located on waterward side.
