**Flood Control Project Maintenance
Levee Inspections**

Fall 2019 Levee Maintenance Deficiency Summary Report

San Joaquin River Basin

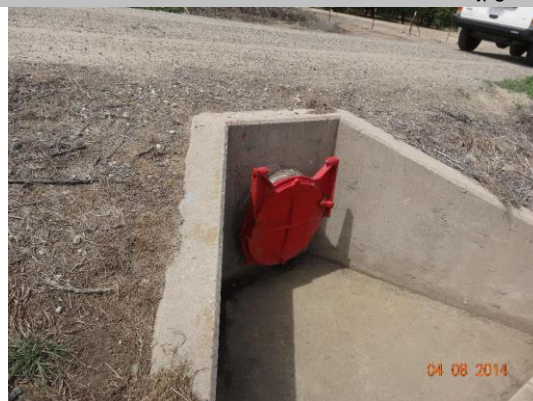
Photo 3 of 3 : UCIP_FA_2019_50056_60106.jpg

Comment Code						
Inspector Comment						
DS_ID:19957 FS_ID:50056 EP_NO: N/A Repair Type: Non-Urgent Crossing Status: Found UCIP Comments: 7/20/2016 same as previous inspection. Crossing has been downgraded from Urgent to Non-Urgent PVC does not prevent WS flap gate from closing. (DWR UCIP - omagana)4/08/2014 Unauthorized PVC pipe through existng crossing. PVC distorted inside--Need to contact owner to correct issue. If crossing was allowed need to contact owner for permit number issue for crossing variance. (DWR UCIP - omagana) FIELD_STRUCT_DESC: 24-inch corrugated metal gravity drainage pipe through the levee, 3.6 feet below the crown. Flap gate on the waterside (WS) end. Concrete headwall on the landside (LS) end. Concrete U-shaped headwall on the WS end. [Additional Reference(s): DWR Levee Log, 2002]. FS Date: 7/20/2016

Flap gate visible on WS.

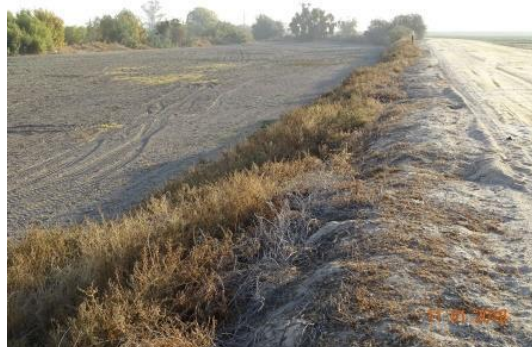
Photo 1 of 1 : FA_2019_NA0010_140_10_20191114_00034.jpg

LM Start	7.20	Rating **	U	Issue No.	10
LM End	7.86	Issue Type +	Ma	Location *	WS
Category	Earthen Levee			GPS Latitude/Longitude	
				Start	End
Item	Vegetation			36.780690°	36.775279°
				-120.200732°	-120.191857°
DWR ID	DWR_NA0010_24_f_2019_10				
Comment Code					
V1 : Control annual grass and weeds on the levee slopes and easements.					
Inspector Comment

View of the waterside slope looking upstream. (Fall 2019)

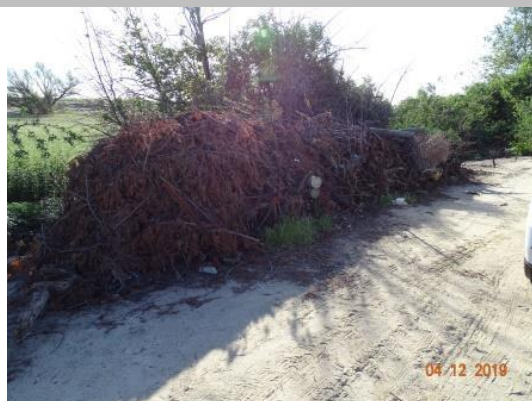
Photo 1 of 1 : FA_2019_NA0010_140_19_20190912_00004.jpg

LM Start	7.38	Rating **	U	Issue No.	19
LM End	7.38	Issue Type +	En	Location *	WS
Category	Earthen Levee			GPS Latitude/Longitude	
				Start	End
Item	Encroachments			36.778838°	36.778838°
				-120.198478°	-120.198478°
DWR ID	DWR_NA0010_24_s_2019_19				
Comment Code					
TR : Tree or limb					
Inspector Comment

View of tree punings left on waterside shoulder. (Spring 2019)

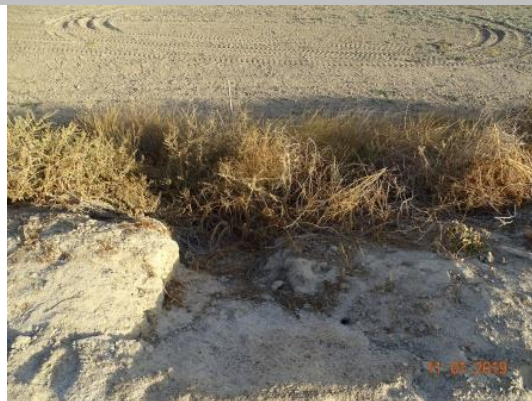
Photo 1 of 1 : FA_2019_NA0010_140_11_20191114_00036.jpg

LM Start	7.83	Rating **	A/W	Issue No.	11
LM End	7.83	Issue Type +	Ma	Location *	WS
Category	Earthen Levee			GPS Latitude/Longitude	
				Start	End
Item	Erosion / Bank Caving			36.775271 °	36.775271 °
				-120.192400 °	-120.192400 °
DWR ID	DWR_NA0010_24_f_2019_11				
Comment Code					
E1 : Note and monitor erosion site.					
Inspector Comment

Looking East down the waterside slope. (Fall 2019)

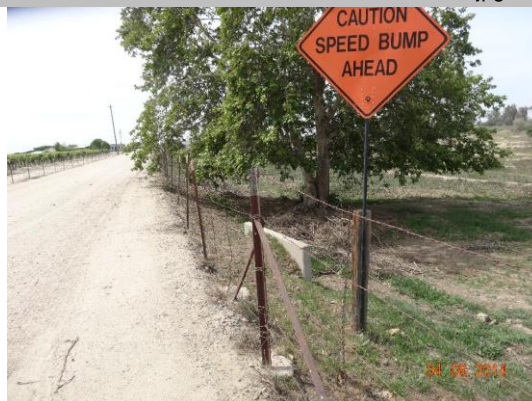
Photo 1 of 2 : UCIP_FA_2019_33272_60121.jpg

LM Start	8.33	Rating **	M	Issue No.	273	
LM End	8.33	Issue Type +	Ma	Location *		
Category	Supplemental			GPS Latitude/Longitude		
				Start		End
Item	DRAFT DWR UCIP LMA Responsibility			36.778084 °		36.778084 °
				-120.184454 °		-120.184454 °
DWR ID	19960					
Comment Code						
Inspector Comment						
DS_ID:19960						
FS_ID:33272						
EP_NO: N/A						
Repair Type: Non-Urgent						
Crossing Status: Found						
UCIP Comments: 04/08/2014 Barbed wire along levee shoulder--no access. Need to confirm crossing size and condition of crossing. (DWR UCIP - O. Magana)						
FIELD_STRUCT_DESC: 12-inch reinforced concrete gravity drainage pipe through the levee, 3 feet below the crown. Flap gate on the waterside (WS) end. Concrete headwall on the WS end. [Additional Reference(s): DWR Levee Log, 2002. USACE San Joaquin O&M Manual 601.1, 1967, (HLM 8.32)].						
FS Date: 4/8/2014

View of waterward side.

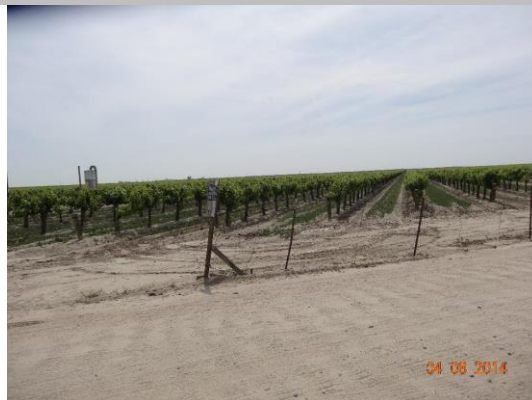
Photo 2 of 2 : UCIP_FA_2019_33272_60120.jpg

View of landward side.

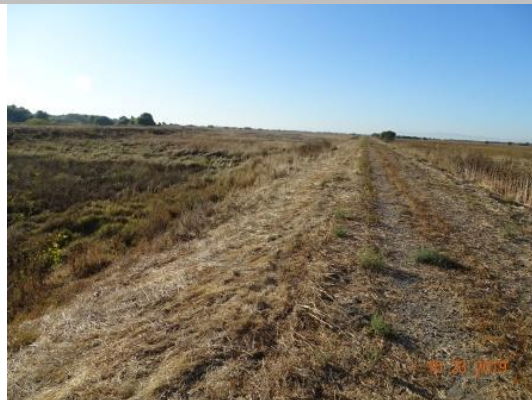
Photo 1 of 1 : FA_2019_NA0010_141_8_20191114_00024.jpg

LM Start	0.01	Rating **	M	Issue No.	8
LM End	2.47	Issue Type +	Ma	Location *	LS
Category	Earthen Levee			GPS Latitude/Longitude	
				Start	End
Item	Vegetation			37.296125°	37.271357°
				-120.880736°	-120.866720°
DWR ID	DWR_NA0010_25_f_2019_8				
Comment Code					
V1 : Control annual grass and weeds on the levee slopes and easements.					
Inspector Comment

View of the landside slope looking upstream. (Fall 2019)

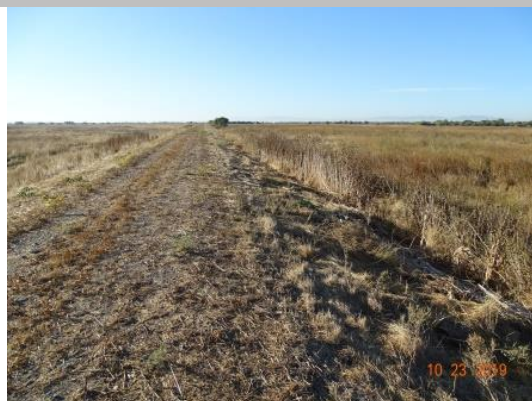
Photo 1 of 1 : FA_2019_NA0010_141_10_20191114_00025.jpg

LM Start	0.01	Rating **	M	Issue No.	10
LM End	2.47	Issue Type +	Ma	Location *	WS
Category	Earthen Levee			GPS Latitude/Longitude	
				Start	End
Item	Vegetation			37.296125°	37.271353°
				-120.880736°	-120.866718°
DWR ID	DWR_NA0010_25_f_2019_10				
Comment Code					
V1 : Control annual grass and weeds on the levee slopes and easements.					
Inspector Comment

View of the waterside slope looking upstream. (Fall 2019)

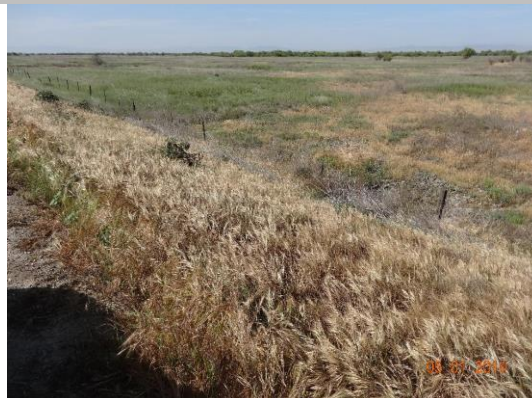
Photo 1 of 3 : UCIP_FA_2019_39501_67242.jpg

Comment Code						
Inspector Comment						
DS_ID:19965 FS_ID:39501 EP_NO: N/A Repair Type: Non-Urgent Crossing Status: Found UCIP Comments: 05/01/2014 Dense vegetation limits the inspectors visibility to identify signs of pipe failure (leaks) along the slope. Recommend removing vegetation along pipe alignment to conduct proper inspection of structure. Sediment buildup in pipe visible from landward side--recommend clearing. (DWR UCIP - O. Magana) FIELD_STRUCT_DESC: 24-inch corrugated metal gravity drainage pipe through the levee, 10 feet below the crown. Flap gate on the waterside (WS) end. [Additional Reference(s): DWR Levee Log, 2002. USACE San Joaquin O&M Manual 601.1, 1967, (HLM 0.02)]. FS Date: 5/1/2014

View of waterward side--dense vegetation on waterward side.

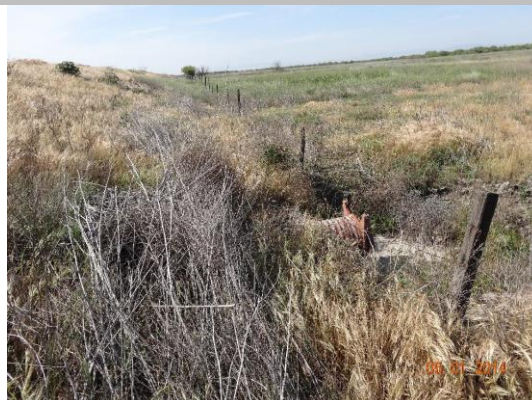
Photo 2 of 3 : UCIP_FA_2019_39501_67240.jpg

Pipe daylight visible on waterward toe.

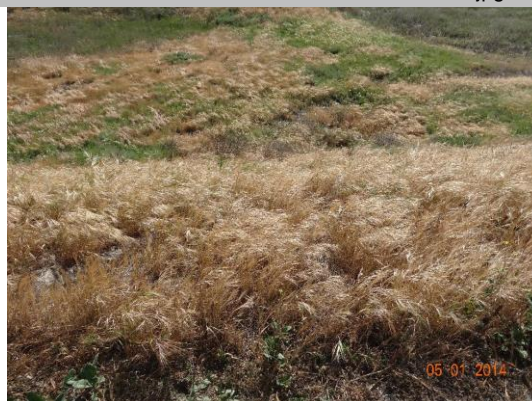
Photo 3 of 3 : UCIP_FA_2019_39501_67241.jpg

Comment Code						
Inspector Comment						
DS_ID:19965 FS_ID:39501 EP_NO: N/A Repair Type: Non-Urgent Crossing Status: Found UCIP Comments: 05/01/2014 Dense vegetation limits the inspectors visibility to identify signs of pipe failure (leaks) along the slope. Recommend removing vegetation along pipe alignment to conduct proper inspection of structure. Sediment buildup in pipe visible from landward side--recommend clearing. (DWR UCIP - O. Magana) FIELD_STRUCT_DESC: 24-inch corrugated metal gravity drainage pipe through the levee, 10 feet below the crown. Flap gate on the waterside (WS) end. [Additional Reference(s): DWR Levee Log, 2002. USACE San Joaquin O&M Manual 601.1, 1967, (HLM 0.02)]. FS Date: 5/1/2014

View of landward side--dense vegetation on landward side.

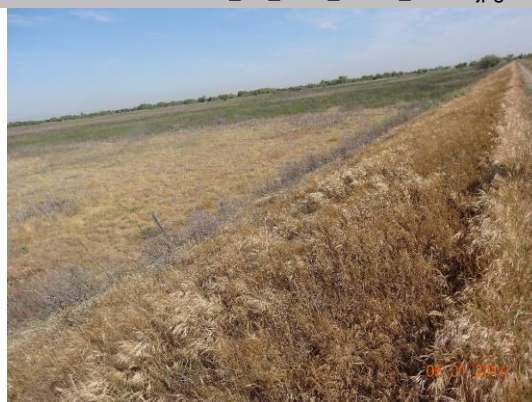
Photo 1 of 3 : UCIP_FA_2019_36851_67249.jpg

Comment Code						
Inspector Comment						
DS_ID:19966						
FS_ID:36851						
EP_NO: N/A						
Repair Type: Non-Urgent						
Crossing Status: Found						
UCIP Comments: 05/01/2014 Dense vegetation limits the inspectors visibility to identify signs of pipe failure (leaks) along the slope.						
Recommend removing vegetation along pipe alignment to conduct proper inspection of structure. (DWR UCIP - O. Magana)						
FIELD_STRUCT_DESC: 24-inch corrugated metal gravity drainage pipe through the levee, 11.6 feet below the crown. Flap gate on the waterside (WS) end. [Additional Reference(s): DWR Levee Log, 2002. USACE San Joaquin O&M Manual 601.1, 1967, (HLM 0.35)].						
FS Date: 5/1/2014

View of waterward side.

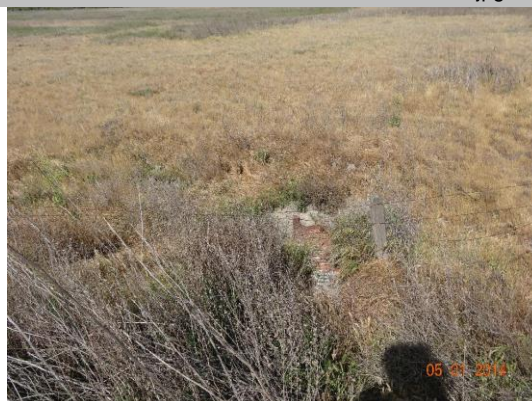
Photo 2 of 3 : UCIP_FA_2019_36851_67248.jpg

Comment Code						
Inspector Comment						
DS_ID:19966 FS_ID:36851 EP_NO: N/A Repair Type: Non-Urgent Crossing Status: Found UCIP Comments: 05/01/2014 Dense vegetation limits the inspectors visibility to identify signs of pipe failure (leaks) along the slope. Recommend removing vegetation along pipe alignment to conduct proper inspection of structure. (DWR UCIP - O. Magana) FIELD_STRUCT_DESC: 24-inch corrugated metal gravity drainage pipe through the levee, 11.6 feet below the crown. Flap gate on the waterside (WS) end. [Additional Reference(s): DWR Levee Log, 2002. USACE San Joaquin O&M Manual 601.1, 1967, (HLM 0.35)]. FS Date: 5/1/2014

Pipe outlet visible on waterward side.

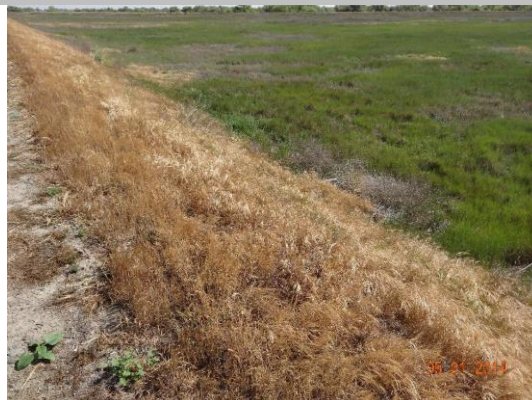
Photo 3 of 3 : UCIP_FA_2019_36851_67247.jpg

View of landward side.

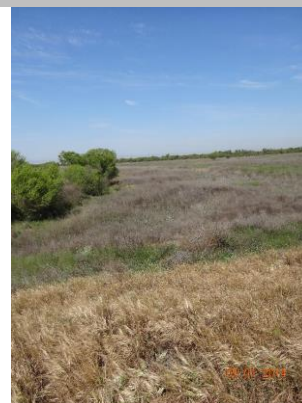
Photo 1 of 3 : UCIP_FA_2019_36852_67250.jpg

Comment Code					
Inspector Comment					
DS_ID:19967					
FS_ID:36852					
EP_NO: N/A					
Repair Type: Non-Urgent					
Crossing Status: Found					
UCIP Comments: 05/01/2014 Dense vegetation limits the inspectors visibility to identify signs of pipe failure (leaks) along the slope.					
Recommend removing vegetation along pipe alignment to conduct proper inspection of structure. (DWR UCIP - O. Magana)					
FIELD_STRUCT_DESC: 24-inch corrugated metal gravity drainage pipe through the levee, 14.7 feet below the crown. Flap gate on the waterside (WS) end. [Additional Reference(s): DWR Levee Log, 2002.					
USACE San Joaquin O&M Manual 601.1, 1967, (HLM 0.59)].					
FS Date: 5/1/2014

Overview of waterward side--Salt Slough.

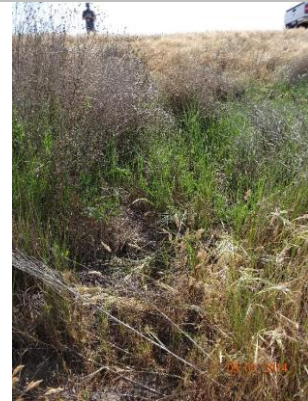
Photo 2 of 3 : UCIP_FA_2019_36852_67251.jpg

Comment Code						
Inspector Comment						
DS_ID:19967						
FS_ID:36852						
EP_NO: N/A						
Repair Type: Non-Urgent						
Crossing Status: Found						
UCIP Comments: 05/01/2014 Dense vegetation limits the inspectors visibility to identify signs of pipe failure (leaks) along the slope.						
Recommend removing vegetation along pipe alignment to conduct proper inspection of structure. (DWR UCIP - O. Magana)						
FIELD_STRUCT_DESC: 24-inch corrugated metal gravity drainage pipe through the levee, 14.7 feet below the crown. Flap gate on the waterside (WS) end. [Additional Reference(s): DWR Levee Log, 2002. USACE San Joaquin O&M Manual 601.1, 1967, (HLM 0.59)].						
FS Date: 5/1/2014

View of waterward slope covered by dense vegetation.

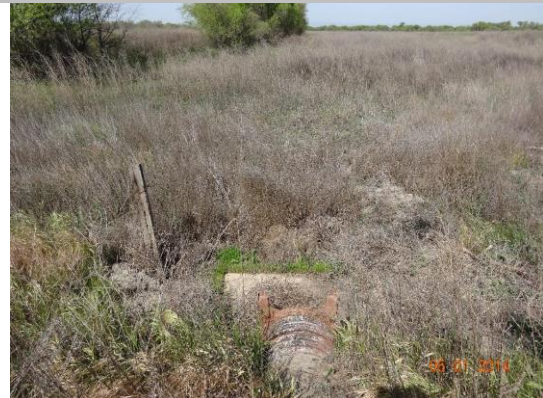
Photo 3 of 3 : UCIP_FA_2019_36852_67252.jpg

Pipe and flap gate visible on waterward side.

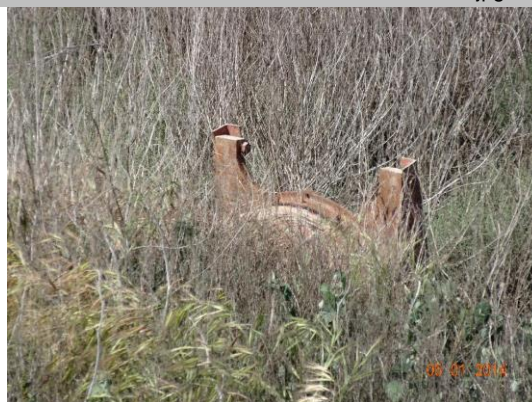
Photo 2 of 3 : UCIP_FA_2019_36853_67255.jpg

Pipe and evidence of flap gate visible on waterward side.

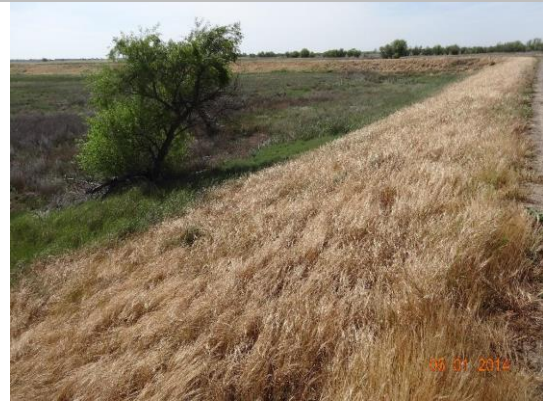
Photo 3 of 3 : UCIP_FA_2019_36853_67254.jpg

Comment Code						
Inspector Comment						
DS_ID:19968						
FS_ID:36853						
EP_NO: N/A						
Repair Type: Non-Urgent						
Crossing Status: Found						
UCIP Comments: 05/01/2014 Dense vegetation limits the inspectors visibility to identify signs of pipe failure (leaks) along the slope.						
Recommend removing vegetation along pipe alignment to conduct proper inspection of structure. (DWR UCIP - O. Magana)						
FIELD_STRUCT_DESC: 24-inch corrugated metal gravity drainage pipe through the levee, 11.4 feet below the crown. Flap gate on the waterside (WS) end. [Additional Reference(s): DWR Levee Log, 2002. USACE San Joaquin O&M Manual 601.1, 1967, (HLM 0.97)].						
FS Date: 5/1/2014

View of landward side.

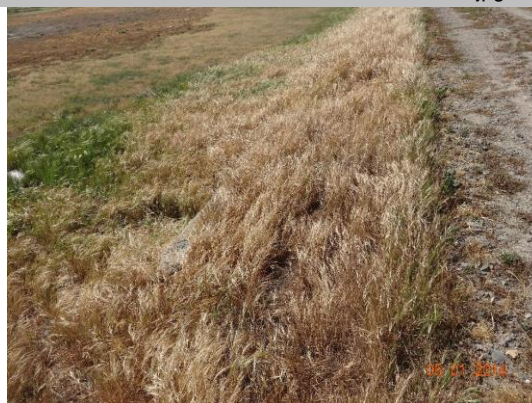
Photo 1 of 3 : UCIP_FA_2019_36854_67259.jpg

Comment Code					
Inspector Comment					
DS_ID:19969					
FS_ID:36854					
EP_NO: N/A					
Repair Type: Non-Urgent					
Crossing Status: Found					
UCIP Comments: 05/01/2014 Dense vegetation limits the inspectors visibility to identify signs of pipe failure (leaks) along the slope.					
Recommend removing vegetation along pipe alignment to conduct proper inspection of structure. (DWR UCIP - O. Magana)					
FIELD_STRUCT_DESC: 24-inch corrugated metal gravity drainage pipe through the levee, 4 feet below the crown. Flap gate on the waterside (WS) end. [Additional Reference(s): DWR Levee Log, 2002. USACE San Joaquin O&M Manual 601.1, 1967, (HLM 2.05)].					
FS Date: 5/1/2014

View of landward side.

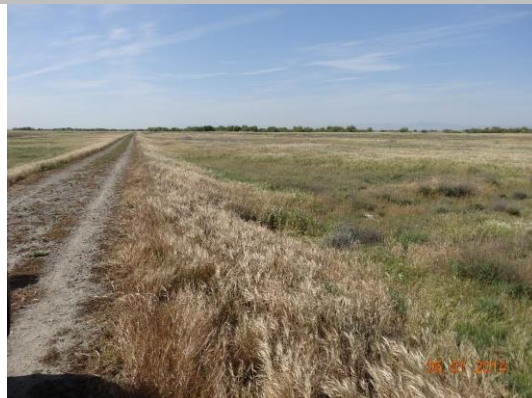
Photo 2 of 3 : UCIP_FA_2019_36854_67260.jpg

Comment Code						
Inspector Comment						
DS_ID:19969						
FS_ID:36854						
EP_NO: N/A						
Repair Type: Non-Urgent						
Crossing Status: Found						
UCIP Comments: 05/01/2014 Dense vegetation limits the inspectors visibility to identify signs of pipe failure (leaks) along the slope.						
Recommend removing vegetation along pipe alignment to conduct proper inspection of structure. (DWR UCIP - O. Magana)						
FIELD_STRUCT_DESC: 24-inch corrugated metal gravity drainage pipe through the levee, 4 feet below the crown. Flap gate on the waterside (WS) end. [Additional Reference(s): DWR Levee Log, 2002. USACE San Joaquin O&M Manual 601.1, 1967, (HLM 2.05)].						
FS Date: 5/1/2014

View of waterward side.

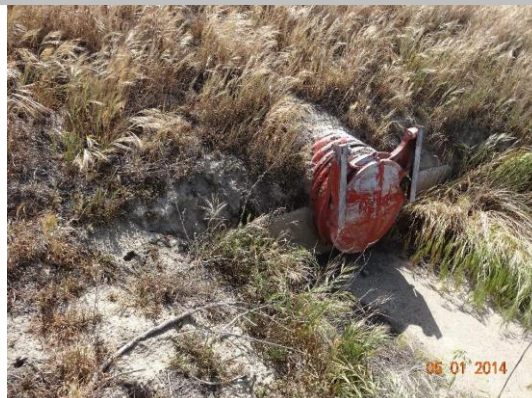
Photo 3 of 3 : UCIP_FA_2019_36854_67261.jpg

Flap gate and concrete headwall located on waterward toe.

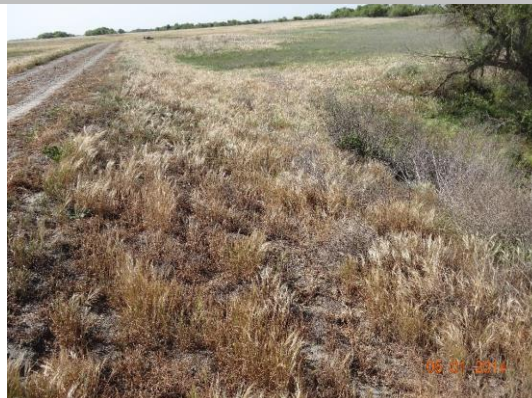
Photo 1 of 3 : UCIP_FA_2019_39502_67270.jpg

Comment Code						
Inspector Comment						
DS_ID:19970 FS_ID:39502 EP_NO: N/A Repair Type: Non-Urgent Crossing Status: Found UCIP Comments: 05/01/2014 Dense vegetation limits the inspectors visibility to identify signs of pipe failure (leaks) along the slope. Recommend removing vegetation along pipe alignment to conduct proper inspection of structure. Sediment buildup in pipe visible on landward side--recommend clearing. (DWR UCIP - O. Magana) FIELD_STRUCT_DESC: 24-inch corrugated metal gravity drainage pipe through the levee, 11.2 feet below the crown. Flap gate on the waterside (WS) end. [Additional Reference(s): DWR Levee Log, 2002. USACE San Joaquin O&M Manual 601.1, 1967, (HLM 2.45)]. FS Date: 5/1/2014 4:04:00 PM

View of waterward side.

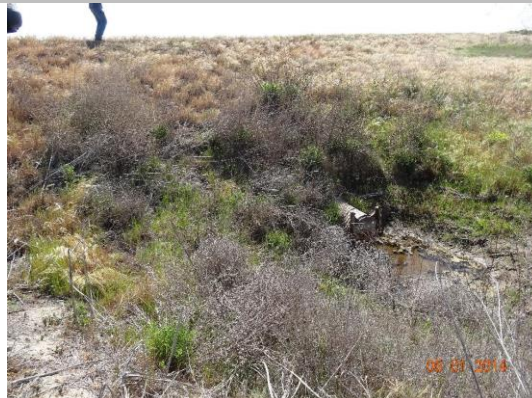
Photo 2 of 3 : UCIP_FA_2019_39502_67269.jpg

Pipe daylights at waterward toe.

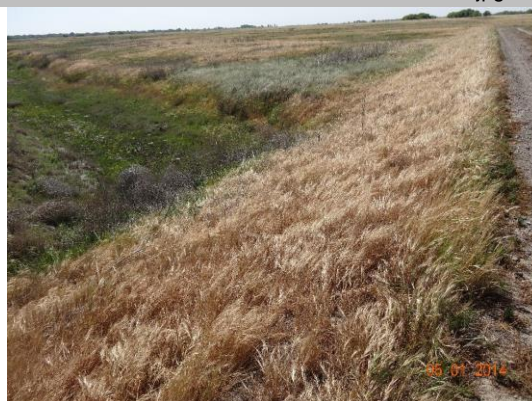
Photo 3 of 3 : UCIP_FA_2019_39502_67268.jpg

Comment Code						
Inspector Comment						
DS_ID:19970 FS_ID:39502 EP_NO: N/A Repair Type: Non-Urgent Crossing Status: Found UCIP Comments: 05/01/2014 Dense vegetation limits the inspectors visibility to identify signs of pipe failure (leaks) along the slope. Recommend removing vegetation along pipe alignment to conduct proper inspection of structure. Sediment buildup in pipe visible on landward side--recommend clearing. (DWR UCIP - O. Magana) FIELD_STRUCT_DESC: 24-inch corrugated metal gravity drainage pipe through the levee, 11.2 feet below the crown. Flap gate on the waterside (WS) end. [Additional Reference(s): DWR Levee Log, 2002. USACE San Joaquin O&M Manual 601.1, 1967, (HLM 2.45)]. FS Date: 5/1/2014 4:04:00 PM

View of landward side.
