Flood Control Project Maintenance Levee Inspections

Fall 2020 Levee Maintenance Deficiency Summary Report

San Joaquin River Basin

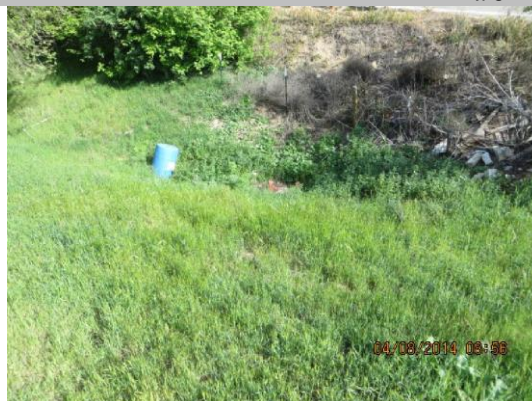
Photo 1 of 3 : UCIP_FA_2020_61818_60601.jpg

DS_ID:19650
FS_ID:61818
EP_NO: N/A
Repair Type: Non-Urgent
EVAL Issue:
Crossing Status: Found
UCIP Comments: 04/08/2014 Dense vegetation limits the inspector's visibility to identify signs of pipe failure (leaks) along the waterward slope and landward toe. Recommend removing vegetation along pipe alignment and landward toe to conduct proper inspection of structure and appurtenances. (W. Wylie - DWR UCIP)
FIELD_STRUCT_DESC: 24-inch corrugated metal gravity drainage pipe through the levee, 10.5 feet below the crown. Flap gate on the waterside (WS) end. Brass cap No. 108 bench mark (BM) on the headwall on the landside (LS), elevation 65.1 feet, USGS Datum.
[Additional Reference(s): DWR Levee Log, 2002 (HLM 0.00), listed as a 24-inch corrugated metal pipe (CMP). USACE San Joaquin O&M Manual, Unit 601 Part 1 (SJR601.1), 1967, Revised 25 May 2011, (HLM 0.02), listed as a 24-inch CMP].
FS Date: 4/8/2014 7:34:00 AM

Flapgate on WS toe.

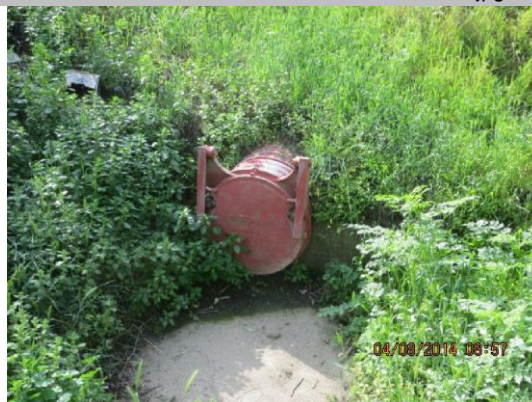
Photo 2 of 3 : UCIP_FA_2020_61818_60600.jpg

Flapgate on WS toe.

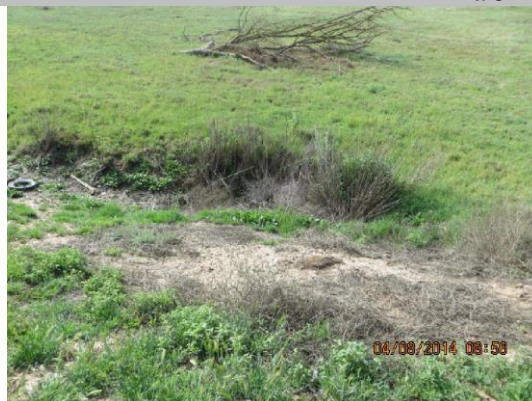
Photo 3 of 3 : UCIP_FA_2020_61818_60602.jpg

Headwall on LS toe.

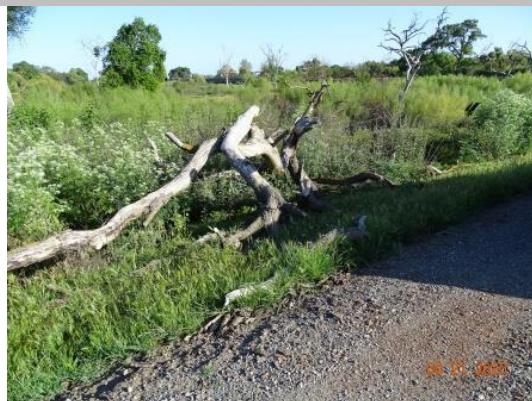
Photo 1 of 1 : FA_2020_NA0010_118_143_20200901_00021.jpg

Downed tree limb should be removed from the waterside shoulder.
(Spring 2020)

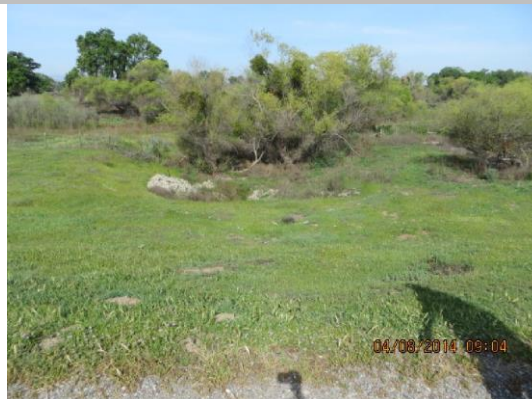
Photo 1 of 3 : UCIP_FA_2020_61819_60611.jpg

DS_ID:19651
FS_ID:61819
EP_NO: N/A
Repair Type: Non-Urgent
EVAL Issue:
Crossing Status: Found
UCIP Comments: 04/08/2014 Pipe has significant sediment buildup and shows some signs of corrosion at landward toe. Recommend cleaning sediment from inside pipe and check wall integrity. (W. Wylie - DWR UCIP)
FIELD_STRUCT_DESC: 36-inch corrugated metal gravity drainage pipe through the levee, 18.5 feet below the crown. Flap gate on the waterside (WS) end. Brass cap No. 108 bench mark (BM) on the headwall on the landside (LS). [Additional Reference(s): DWR Levee Log, 2002 (HLM 0.35), listed as 36-inch corrugated metal pipe (CMP). USACE San Joaquin O&M Manual, Unit 601 Part 1 (SJR601.1), 1967, Revised 25 May 2011, (HLM 0.35), listed as a 36-inch CMP].
FS Date: 4/8/2014

Flapgate and headwall visible off WS toe.

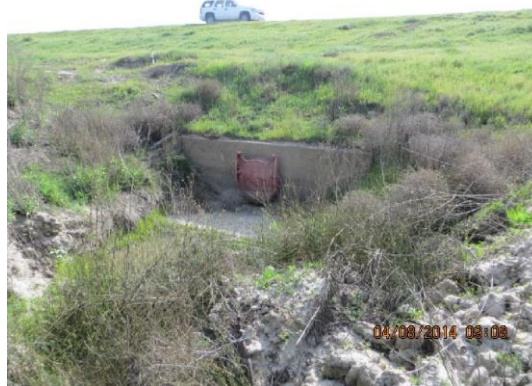
Photo 2 of 3 : UCIP_FA_2020_61819_60613.jpg

Flapgate and headwall visible off WS toe.

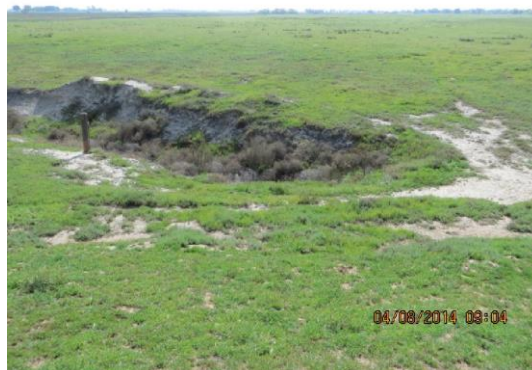
Photo 3 of 3 : UCIP_FA_2020_61819_60612.jpg

Pipe and headwall visible off LS toe.

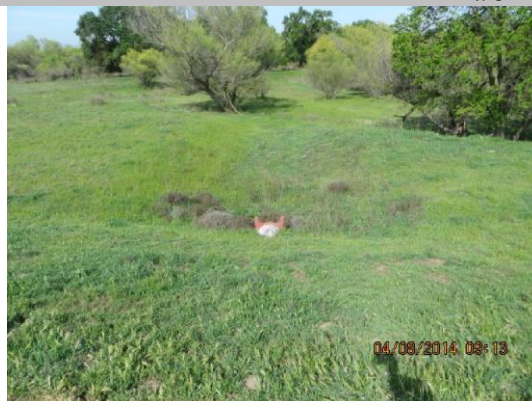
Photo 1 of 3 : UCIP_FA_2020_61820_60622.jpg

| DS_ID:19583 FS_ID:61820 EP_NO: N/A Repair Type: Non-Urgent EVAL Issue: Crossing Status: Found UCIP Comments: 04/08/2014 Recommend removing vegetation pile from waterward toe. (W. Wylie - DWR UCIP) FIELD_STRUCT_DESC: 24-inch corrugated metal gravity drainage pipe through the levee, 8.5 feet below the crown. Flap gate on the waterside (WS) end. Brass cap No. 108 bench mark (BM) on the headwall on the landside (LS). [Additional Reference(s): DWR Levee Log, 2002 (HLM 0.62), listed as a 24-inch corrugated metal pipe (CMP). USACE San Joaquin O&M Manual, Unit 601 Part 1 (SJR601.1), 1967, Revised 25 May 2011, (HLM 0.62), listed as a 24-inch CMP]. FS Date: 4/8/2014 | | | | | |

Flapgate and headwall visible on WS toe.

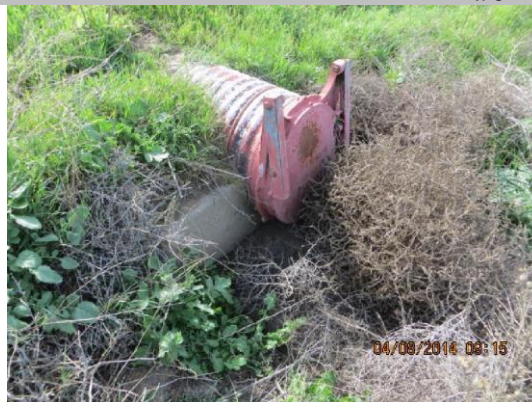
Photo 2 of 3 : UCIP_FA_2020_61820_60623.jpg

Flapgate and headwall visible on WS toe.

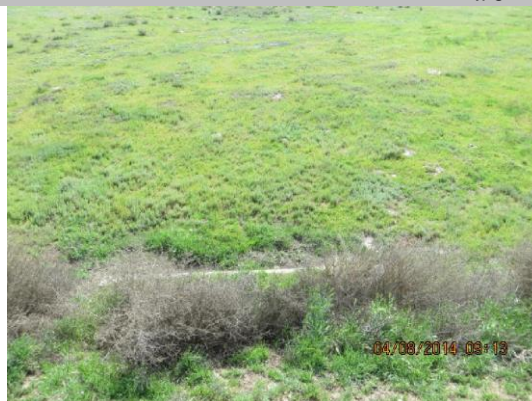
Photo 3 of 3 : UCIP_FA_2020_61820_60621.jpg

Pipe and headwall visible on LS toe.

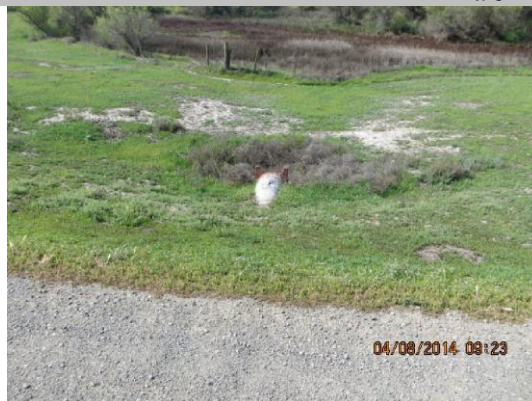
Photo 1 of 3 : UCIP_FA_2020_61823_60632.jpg

DS_ID:19585
FS_ID:61823
EP_NO: N/A
Repair Type: Non-Urgent
EVAL Issue:
Crossing Status: Found
UCIP Comments: 04/08/2014 Moderate erosion around headwall on landward toe. May or may not be an issue. Need to contact owner to determine status of crossing and to address erosion issue on landward side. (W. Wylie - DWR UCIP)
FIELD_STRUCT_DESC: 24-inch corrugated metal gravity drainage pipe through the levee, 9 feet below the crown. Flap gate on the waterside (WS) end. Brass cap No. 108 bench mark (BM) on the headwall on the landside (LS). [Additional Reference(s): DWR Levee Log, 2002 (HLM 0.96), listed as a 24-inch corrugated metal pipe (CMP). USACE San Joaquin O&M Manual, Unit 601 Part 1 (SJR601.1), 1967, Revised 25 May 2011, (HLM 0.95), listed as a 24-inch CMP].
FS Date: 4/8/2014

Flapgate, pipe, and headwall on WS toe.

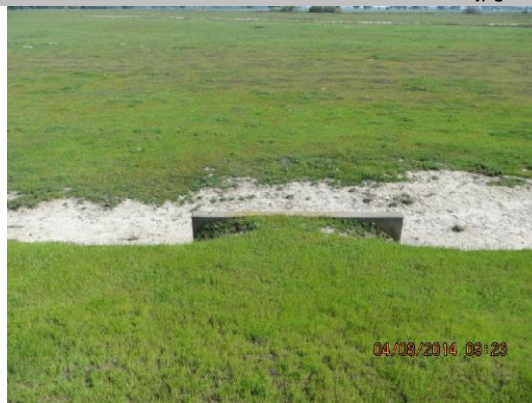
Photo 2 of 3 : UCIP_FA_2020_61823_60631.jpg

Concrete headwall and pipe visible at LS toe.

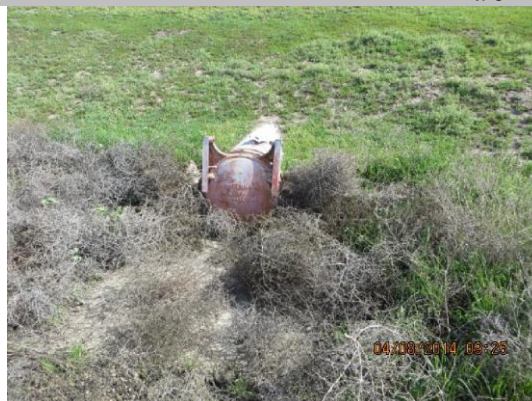
Photo 3 of 3 : UCIP_FA_2020_61823_60633.jpg

Flapgate, pipe, and headwall on WS toe.

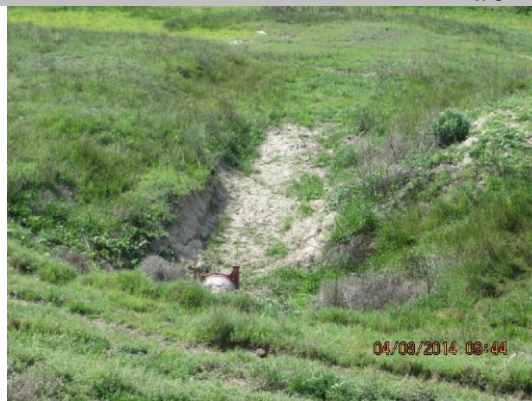
Photo 1 of 3 : UCIP_FA_2020_61827_60661.jpg

| DS_ID:19589 FS_ID:61827 EP_NO: N/A Repair Type: Non-Urgent EVAL Issue: Crossing Status: Found UCIP Comments: 04/08/2014 Heavy sediment buildup in pipe at LS toe. (DWR UCIP - W. Wylie) FIELD_STRUCT_DESC: 24-inch corrugated metal gravity drainage pipe through the levee, 13.6 feet below the crown. Flap gate on the waterside (WS) end. Brass cap No. 108 bench mark (BM) on the headwall on the landside (LS). [Additional Reference(s): DWR Levee Log, 2002 (HLM 1.70), listed as a 24-inch corrugated metal pipe (CMP). USACE San Joaquin O&M Manual, Unit 601 Part 1 (SJR601.1), 1967, Revised 25 May 2011, (HLM 1.69), listed as a 24-inch CMP]. FS Date: 4/8/2014 | | | | | |

Pipe, headwall, and flapgate visible on WS toe.

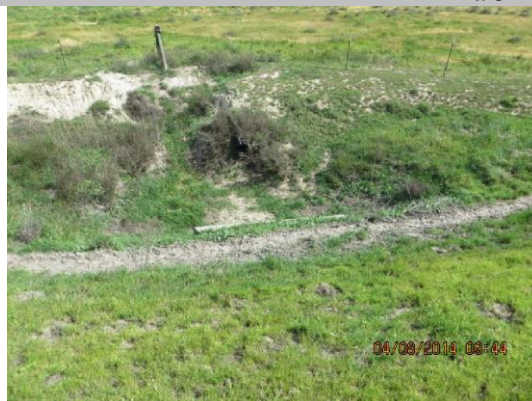
Photo 3 of 3 : UCIP_FA_2020_61827_60662.jpg

Pipe and headwall visible on LS toe.

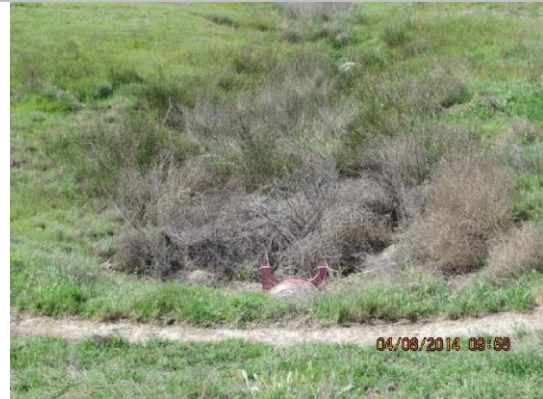
Photo 1 of 3 : UCIP_FA_2020_61829_60670.jpg

DS_ID:19591
FS_ID:61829
EP_NO: N/A
Repair Type: Non-Urgent
EVAL Issue:
Crossing Status: Found
UCIP Comments: 04/08/2014 Need to contact owner to determine crossing status. Inlet drop box silted in and needs to be cleaned out. (W. Wylie - DWR UCIP)
FIELD_STRUCT_DESC: 24-inch corrugated metal gravity drainage pipe through the levee, 9.7 feet below the crown. Flap gate on the waterside (WS) end. Brass cap No. 100 bench mark (BM) on the headwall on the landside (LS). Wooden barrier around drop inlet on the LS toe. [Additional Reference(s): DWR Levee Log, 2002 (HLM 1.98), listed as a 24-inch corrugated metal pipe (CMP). USACE San Joaquin O&M Manual, Unit 601 Part 1 (SJR601.1), 1967, Revised 25 May 2011, (HLM 1.98), listed as a 24-inch CMP].
FS Date: 4/8/2014

Concrete headwall and flapgate on WS toe.

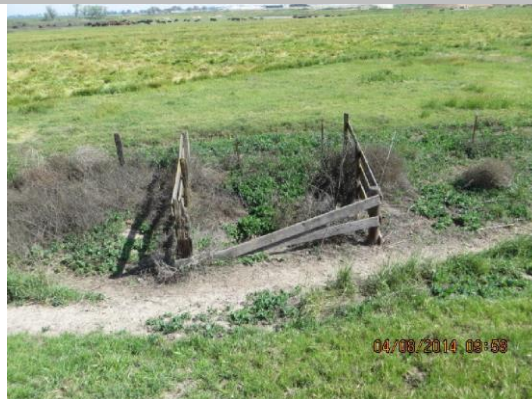
Photo 3 of 3 : UCIP_FA_2020_61829_60671.jpg

Wooded barrier around drop-inlet on LS toe.

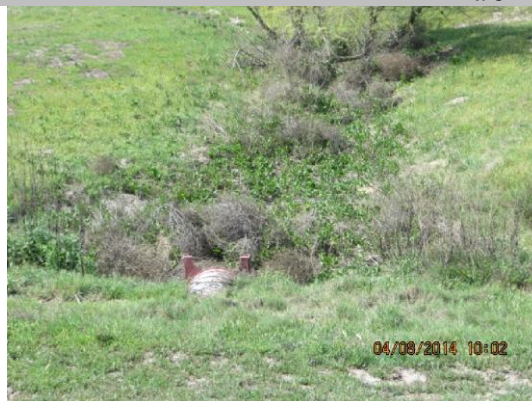
Photo 1 of 3 : UCIP_FA_2020_61830_60675.jpg

| DS_ID:19570 FS_ID:61830 EP_NO: N/A Repair Type: Non-Urgent EVAL Issue: Crossing Status: Found UCIP Comments: 04/08/2014 Unable to find inlet on landward toe. Recommend clearing vegetation on landward side to properly inspect inlet. (W. Wylie - DWR UCIP) FIELD_STRUCT_DESC: 24-inch corrugated metal gravity drainage pipe through the levee, 9.8 feet below the crown. Flap gate on the waterside (WS) end. Brass cap No. 100 bench mark (BM) on the headwall on the landside (LS). [Additional Reference(s): DWR Levee Log, 2002 (HLM 2.08), listed as a 24-inch corrugated metal pipe (CMP). USACE San Joaquin O&M Manual, Unit 601 Part 1 (SJR601.1), 1967, Revised 25 May 2011, (HLM 2.08), listed as a 24-inch CMP]. FS Date: 4/8/2014 | | | | | | |

Pipe and flapgate visible on WS toe.

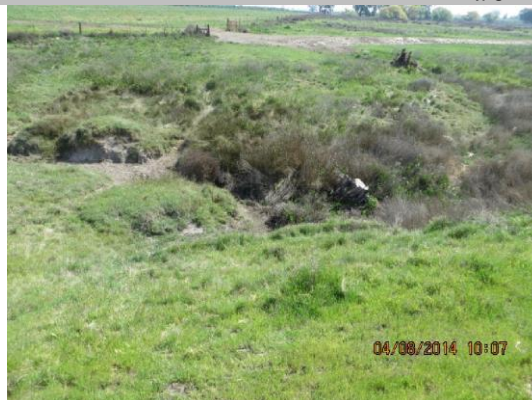
Photo 2 of 3 : UCIP_FA_2020_61831_71308.jpg

| DS_ID:19571 FS_ID:61831 EP_NO: N/A Repair Type: No Action Needed EVAL Issue: Crossing Status: Found UCIP Comments: FIELD_STRUCT_DESC: 36-inch corrugated metal gravity drainage pipe through the levee, 12.6 feet below the crown. Flap gate on the waterside (WS) end. Brass cap No. 100 bench mark (BM) on the headwall on the landside (LS). Wooden barrier around drop inlet on the LS toe. [Additional Reference(s): DWR Levee Log, 2002 (HLM 2.25), listed as a 36-inch corrugated metal pipe (CMP). USACE San Joaquin O&M Manual, Unit 601 Part 1 (SJR601.1), 1967, Revised 25 May 2011, (HLM 2.25), listed as a 36-inch CMP]. FS Date: 4/8/2014 | | | | | | |

Pipe and headwall on LS toe.

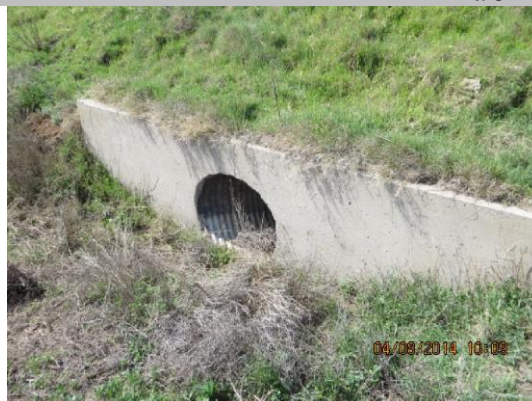
Photo 3 of 3 : UCIP_FA_2020_61831_71307.jpg

Pipe and headwall on LS toe.

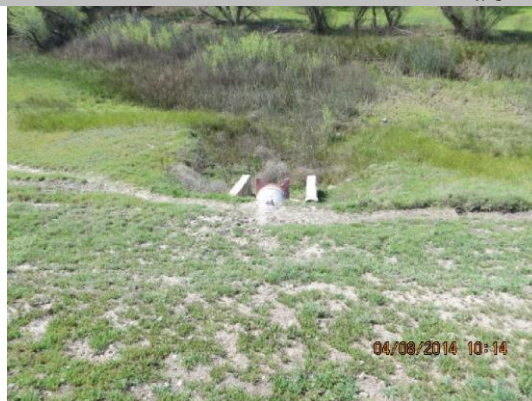
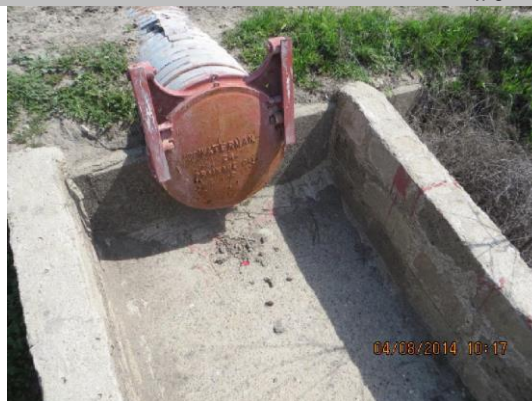
DS_ID:19572
 FS_ID:61832
 EP_NO: N/A
 Repair Type: No Action Needed
 EVAL Issue:
 Crossing Status: Found
 UCIP Comments:
 FIELD_STRUCT_DESC: 24-inch corrugated metal gravity drainage pipe through the levee, 8 feet below the crown. Flap gate on the waterside (WS) end. Brass cap No. 100 bench mark (BM) on the headwall on the landside (LS). [Additional Reference(s): DWR Levee Log, 2002 (HLM 2.53), listed as a 24-inch corrugated metal pipe (CMP). USACE San Joaquin O&M Manual 601.1, 1967, (HLM 2.52), listed as 24-inch CMP].
 FS Date: 4/8/2014

Pipe, headwall, and flapgate on WS toe.

Pipe and headwall on LS toe.

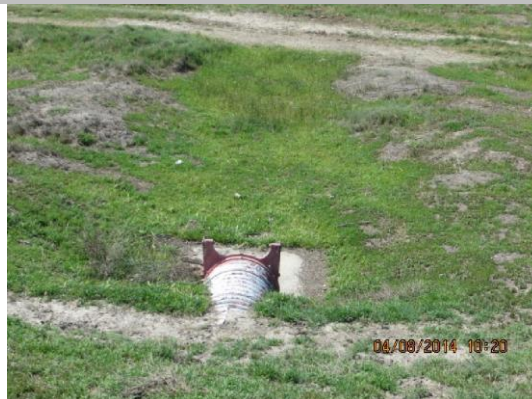
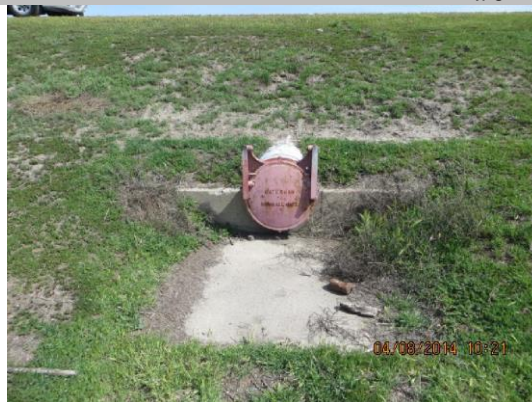
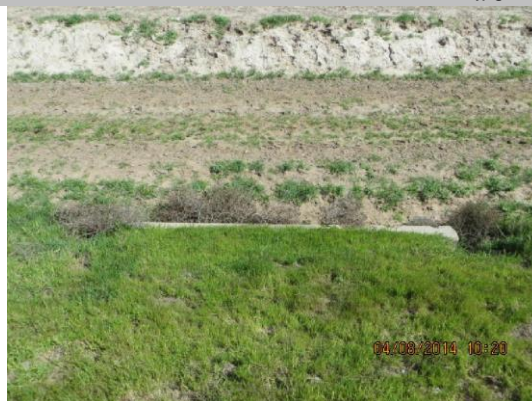
| DS_ID:19573 FS_ID:61833 EP_NO: N/A Repair Type: Non-Urgent EVAL Issue: Crossing Status: Found UCIP Comments: 04/08/2014 Sedimentation in pipe at landward toe. (W. Wylie - DWR UCIP) FIELD_STRUCT_DESC: 24-inch corrugated metal gravity drainage pipe through the levee, 7.3 feet below the crown. Flap gate on the waterside (WS) end. Brass cap No. 100 bench mark (BM) on the headwall on the landside (LS). [Additional Reference(s): DWR Levee Log, 2002 (HLM 2.71), listed as a 24-inch corrugated metal pipe (CMP). USACE San Joaquin O&M Manual, Unit 601 Part 1 (SJR601.1), 1967, Revised 25 May 2011, (HLM 2.70), listed as a 24-inch CMP]. FS Date: 4/8/2014 | | | | | | |

Pipe, flapgate, and headwall on WS toe.

Pipe and headwall on LS toe.

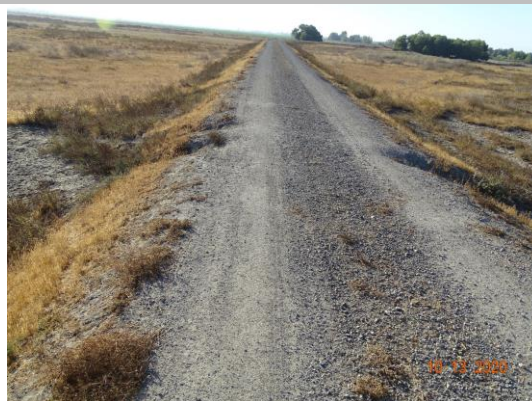
Photo 1 of 1 : FA_2020_NA0010_118_114_20201020_00263.jpg

| Slope damage caused by livestock on both landside and waterside slope. | | | | | |

View of damage to both slope from livestock activity. (Fall 2020)

| A2 : Repair the levee slope damaged by livestock and prevent large animal access. | | | | | |

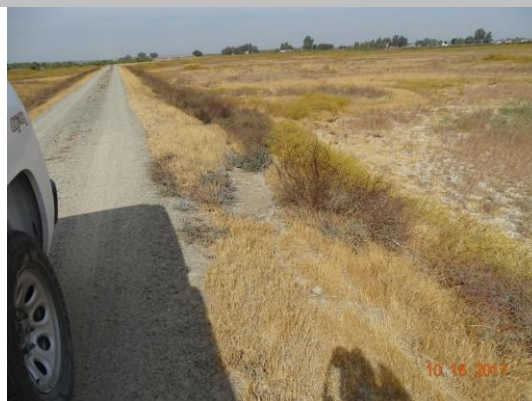
Photo 1 of 1 : FA_2020_NA0010_118_104_20200901_00007.jpg

| Slope damage caused by foot traffic. | | | | | |

Looking northeast at the landside slope. (Fall 2017)

| A2 : Repair the levee slope damaged by livestock and prevent large animal access. | | | | | |

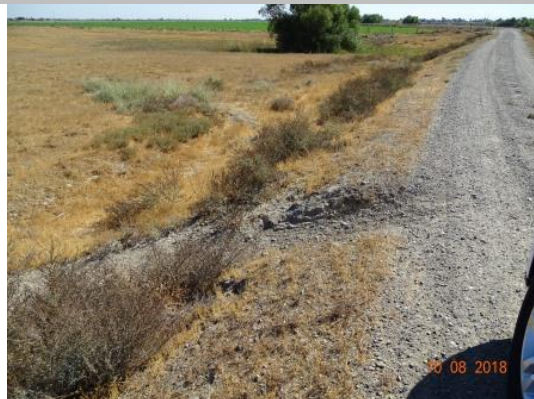
Photo 1 of 1 : FA_2020_NA0010_118_115_20200901_00014.jpg

| Damage caused by livestock traffic. | | | | | |

View of erosion path looking downstream. (Fall 2018)

| A2 : Repair the levee slope damaged by livestock and prevent large animal access. | | | | | |

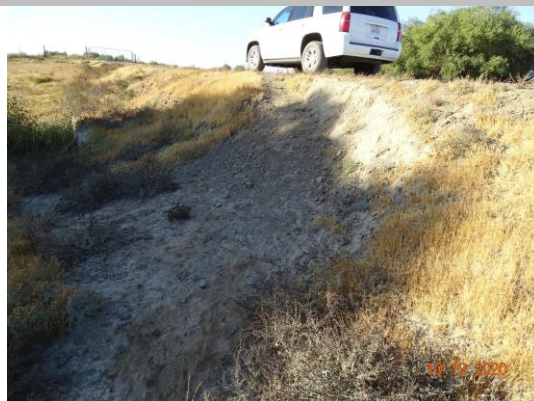
Photo 1 of 1 : FA_2020_NA0010_118_108_20201020_00264.jpg

| Slope damage caused by animal traffic on landside toe. | | | | | |

View of landside slope damage by animal traffic. (Fall 2020)

| A2 : Repair the levee slope damaged by livestock and prevent large animal access. | | | | | |

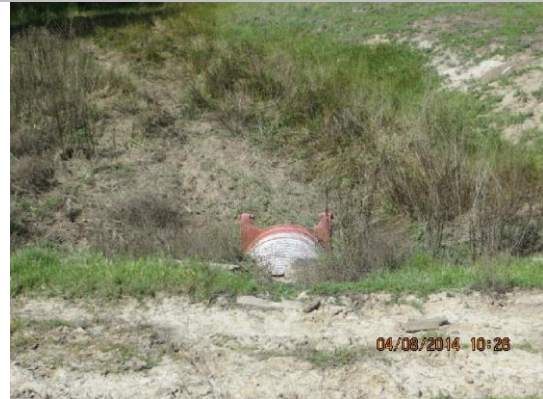
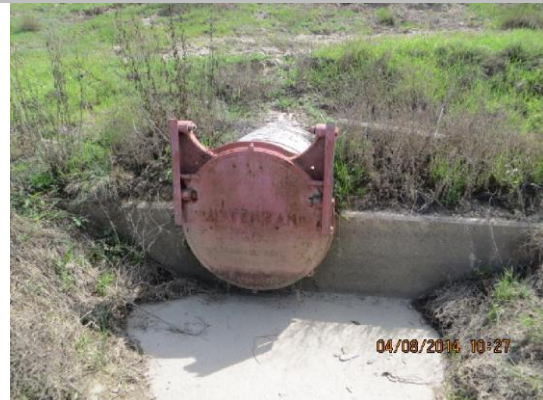
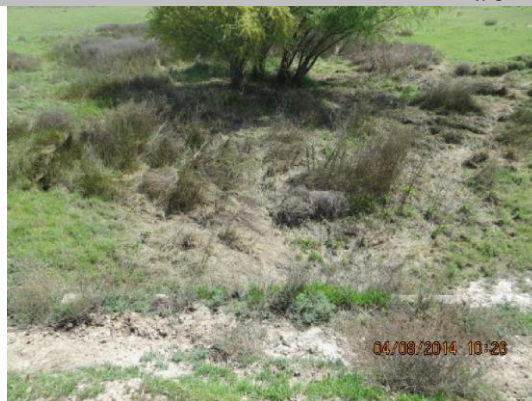
| DS_ID:19574 FS_ID:61834 EP_NO: N/A Repair Type: Non-Urgent EVAL Issue: Crossing Status: Found UCIP Comments: 04/08/2014 Some minor erosion around headwall on LS toe. (W. Wylie - DWR UCIP) FIELD_STRUCT_DESC: 36-inch corrugated metal gravity drainage pipe through the levee, 8 feet below the crown. Flap gate on the waterside (WS) end. Brass cap No. 100 bench mark (BM) on the headwall on the landside (LS). [Additional Reference(s): DWR Levee Log, 2002 (HLM 3.17), listed as a 36-inch corrugated metal pipe (CMP). USACE San Joaquin O&M Manual, Unit 601 Part 1 (SJR601.1), 1967, Revised 25 May 2011, (HLM 3.16), listed as a 36-inch CMP]. FS Date: 4/8/2014 | | | | | | |

Pipe, Flapgate, and headwall on WS toe.

Pipe and headwall on LS toe.

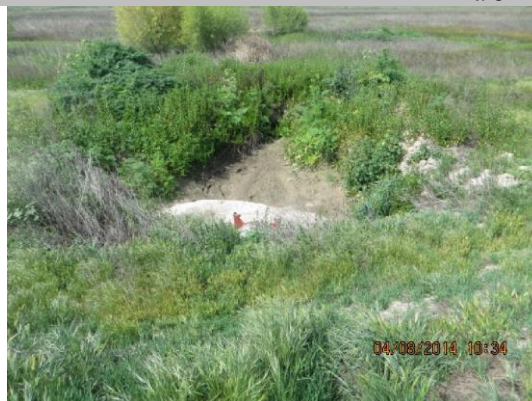
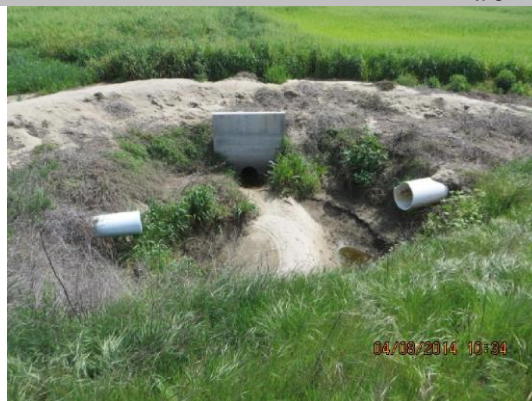
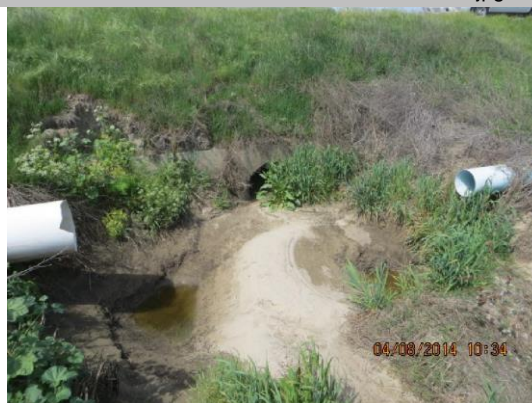
| DS_ID:19575 FS_ID:61835 EP_NO: N/A Repair Type: Urgent EVAL Issue: Crossing Status: Found UCIP Comments: 11/01/2018 Pipe continues to rust through, causing the pipe to collapse on the LS. Sediment buildup visible from the LS inlet. Loss of soil just above the LS concrete headwall and along the LS slope. Crossing remains Urgent due to the levee slope issues and pipe failure through the levee. (O. Magana - DWR UCIP)07/19/2016 Same as previous inspection. Erosion present on LS slope. (O. Magana - DWR UCIP)04/08/2014 Pipe rusted through at Springline on LS toe. Flapgate blocked by sediment on WS toe. Heavy sediment on both ends of pipe. Need to contact owner to address issues. (W. Wylie - DWR UCIP) FIELD_STRUCT_DESC: 36-inch corrugated metal gravity drainage pipe through the levee, 9.7 feet below the crown. Flap gate on the waterside (WS) end. Brass cap No. 100 bench mark (BM) on the headwall on the landside (LS). [Additional Reference(s): DWR Levee Log, 2002 (HLM 3.50), listed as a 36-inch corrugated metal pipe (CMP). USACE San Joaquin O&M Manual, Unit 601 Part 1 (SJR601.1), 1967, Revised 25 May 2011, (HLM 3.50), listed as a 36-inch CMP]. FS Date: 11/1/2018 12:49:00 PM | | | | | | |

Pipe, headwall, and flapgate on WS toe.

Pipe and headwall on LS toe.

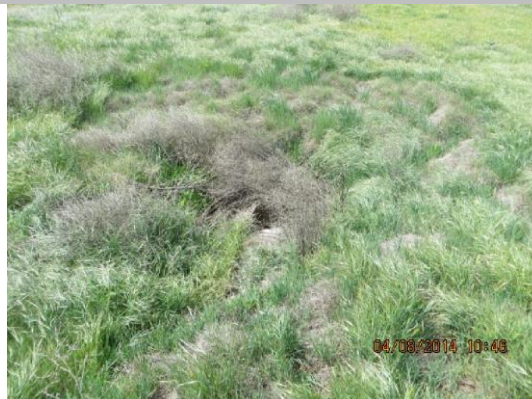
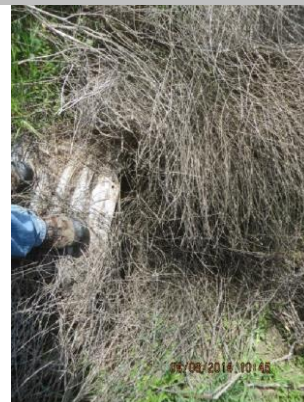
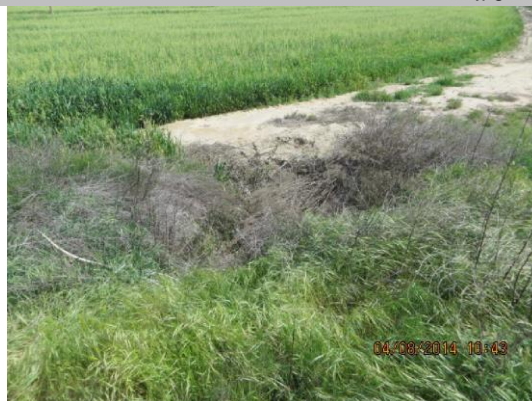
| DS_ID:19576 FS_ID:61836 EP_NO: N/A Repair Type: Non-Urgent EVAL Issue: Crossing Status: Found UCIP Comments: 04/08/2014 Slide gate missing from WS. No closure device, but degrading of levee at Highway 140 is lower than pipe, so this does not appear to be a critical issue. Also dense vegetation limits the inspector's visibility to identify signs of pipe failure (leaks) along the slope. Recommend removing vegetation along pipe alignment to conduct proper inspection of structure and appurtenances. (W. Wylie - DWR UCIP) FIELD_STRUCT_DESC: 30-inch corrugated metal gravity drainage pipe through the levee, 3.5 feet below the crown. Flap gate on the waterside (WS) end. Brass cap No. 100 bench mark (BM) on the headwall on the landside (LS). [Additional Reference(s): DWR Levee Log, 2002 (HLM 3.95), listed as a 30-inch corrugated metal pipe (CMP). USACE San Joaquin O&M Manual, Unit 601 Part 1 (SJR601.1), 1967, Revised 25 May 2011, (HLM 3.95), listed as a 30-inch CMP]. FS Date: 4/8/2014 | | | | | | |

Slide gate missing on WS toe with heavy vegetation camouflaging pipe

Concrete headwall in heavy vegetation at LS toe.

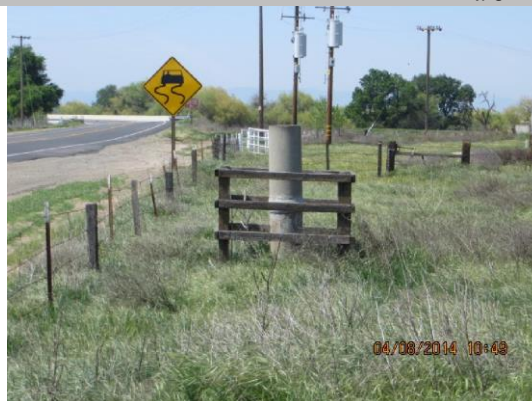
DS_ID:19606
 FS_ID:61837
 EP_NO: N/A
 Repair Type: Non-Urgent
 EVAL Issue:
 Crossing Status: Indicator Found
 UCIP Comments: 04/08/2014 Need to contact owner to determine status of crossing inlet and outlet not found. (W. Wylie - DWR UCIP)
 FIELD_STRUCT_DESC: 12-inch reinforced concrete irrigation discharge pipe through the levee, 3.5 feet below the crown. 12-inch concrete standpipe off each side of the levee. [Additional Reference(s): DWR Levee Log, 2002 (HLM 3.96), listed as a 12-inch concrete pipe].
 FS Date: 4/8/2014

12-inch concrete standpipe off WS toe.

12-inch concrete standpipe off LS toe.

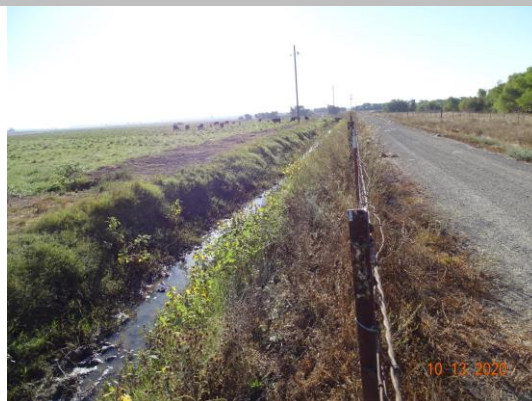
Photo 1 of 1 : FA_2020_NA0010_118_5_20201020_00265.jpg

| Irrigation ditch at landside toe. | | | | | |

Looking south at irrigation ditch at the landside toe. (Fall 2020)

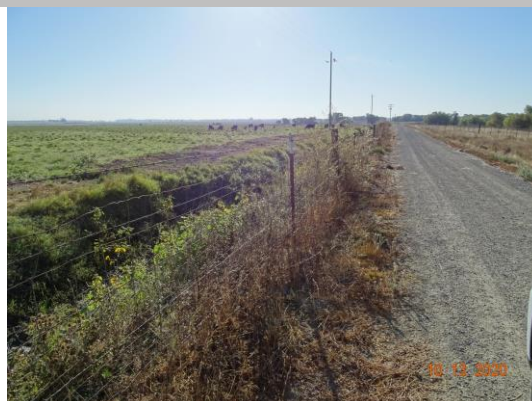
Photo 1 of 1 : FA_2020_NA0010_118_118_20201020_00266.jpg

| Fence along landside toe. | | | | | |

View of fence on the landside shoulder and toe. (Fall 2020)

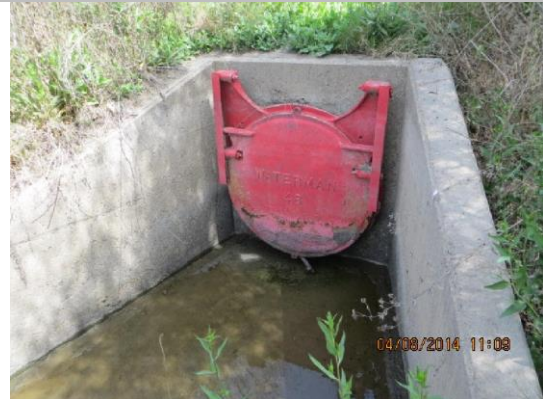
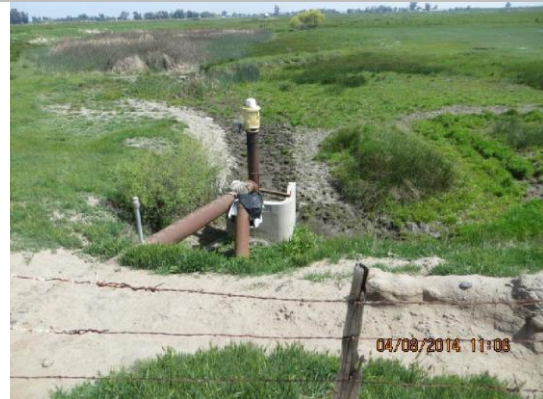
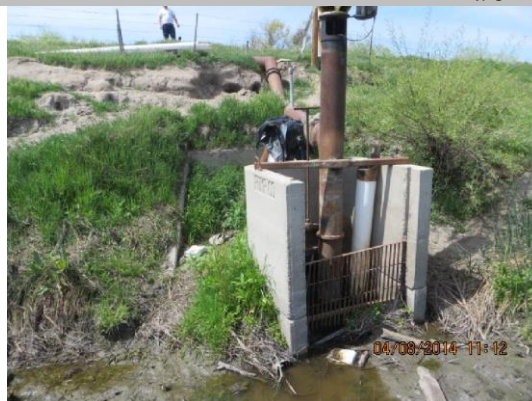
DS_ID:19607
FS_ID:61838
EP_NO: N/A
Repair Type: Non-Urgent
EVAL Issue:
Crossing Status: Found
UCIP Comments: 04/08/2014 Pipe appears sleeved with a 12-inch steel pipe with a slide gate at the LS toe. No identified authorization for changes to this crossing. Need to contact owner to obtain additional information about the modifications to crossing. (W. Wylie - DWR UCIP)
FIELD_STRUCT_DESC: 48-inch corrugated metal gravity drainage pipe through the levee, 14 feet below the crown. Flap gate on the waterside (WS) end. Brass cap No. 90 bench mark (BM) on the headwall on the landside (LS). [Additional Reference(s): DWR Levee Log, 2002 (HLM 4.16), listed as a 48-inch pipe. USACE San Joaquin O&M Manual, Unit 601 Part 1 (SJR601.1), 1967, Revised 25 May 2011, (HLM 4.16), listed as a 48-inch corrugated metal pipe (CMP)].
FS Date: 4/8/2014

Concrete headwall and 48-inch flapgate visible on WS toe.

Assumed pipe exists under pump at LS toe.

Concrete inlet, slidegate, and concrete headwall at LS toe.

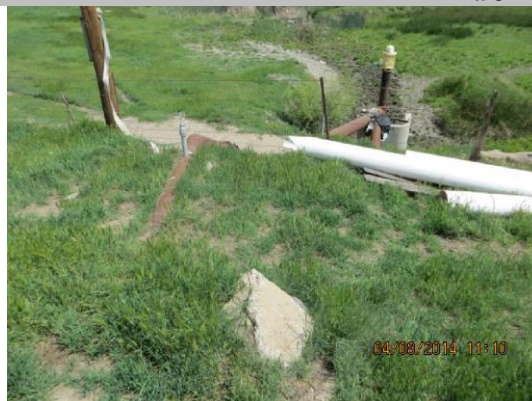
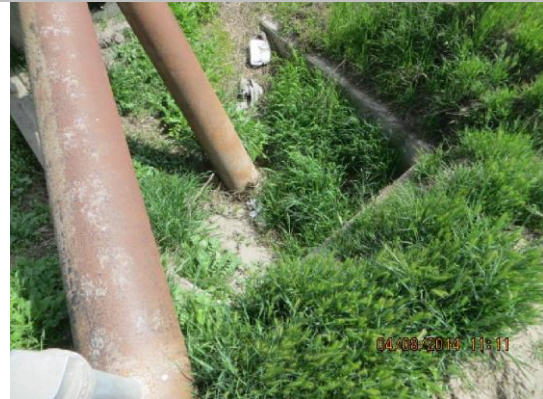
DS_ID:24866
 FS_ID:61839
 EP_NO: N/A
 Repair Type: Non-Urgent
 EVAL Issue:
 Crossing Status: Found
 UCIP Comments: 04/08/2014 Need to contact owner to get details of crossing. (W. Wylie - DWR UCIP)
 FIELD_STRUCT_DESC: 12-inch steel drainage discharge pipe through the levee, 2.5 feet below the crown. 12-inch steel pipe, vent, and pump on stand visible on the landside (LS) slope. 10-inch polyvinyl chloride (PVC) pipe visible on the waterside (WS) slope.
 FS Date: 4/8/2014

View of pipe visible on landward side.

Pipe through existing 48 inch pipe.

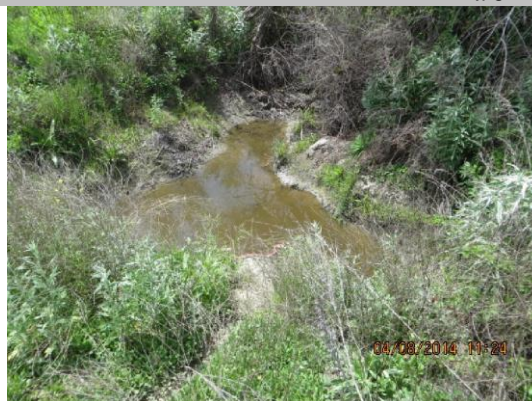
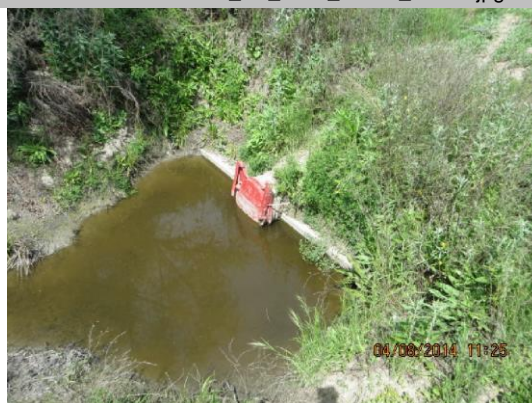
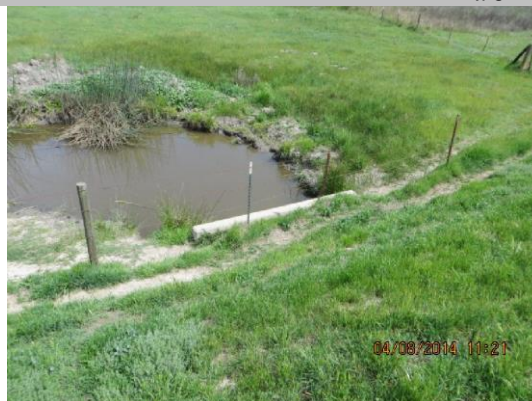
DS_ID:19608
FS_ID:61840
EP_NO: N/A
Repair Type: Non-Urgent
EVAL Issue:
Crossing Status: Found
UCIP Comments: 04/08/2014 Dense vegetation and fence limits the inspector's visibility to identify signs of pipe failure (leaks) along the landward side. Recommend obtaining access to landward toe and removing vegetation along pipe alignment to conduct proper inspection of structure and appurtenances. (W. Wylie - DWR UCIP)
FIELD_STRUCT_DESC: 24-inch corrugated metal gravity drainage pipe through the levee, 11.9 feet below the crown. Flap gate on the waterside (WS) end. Brass cap No. 90 bench mark (BM) on the headwall on the landside (LS). [Additional Reference(s): DWR Levee Log, 2002 (HLM 4.27), listed as a 24-inch corrugated metal pipe (CMP). USACE San Joaquin O&M Manual, Unit 601 Part 1 (SJR601.1), 1967, Revised 25 May 2011, (HLM 4.27), listed as a 24-inch CMP].
FS Date: 4/8/2014

Pipe, flapgate, and headwall visible at WS toe.

Concrete headwall at LS toe.

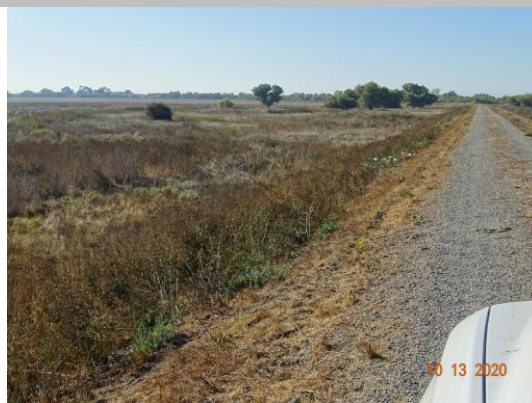
Photo 1 of 1 : FA_2020_NA0010_118_96_20201020_00267.jpg

View of the landside slope looking upstream. (Fall 2020)

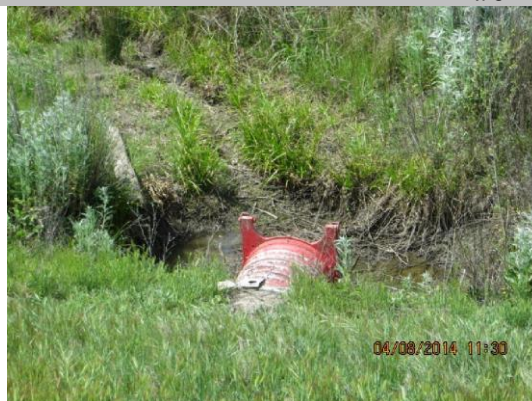
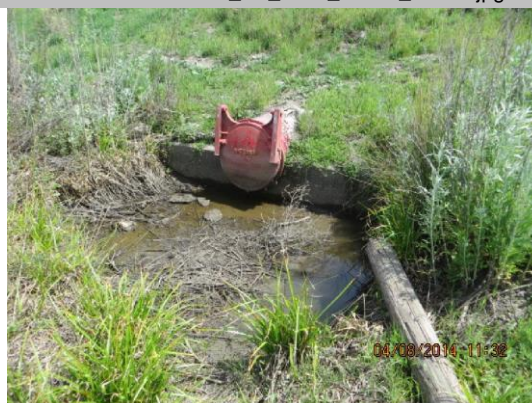
DS_ID:19609
FS_ID:61841
EP_NO: N/A
Repair Type: Non-Urgent
EVAL Issue:
Crossing Status: Found
UCIP Comments: 04/08/2014 Dense vegetation limits the inspector's visibility to identify signs of pipe failure (leaks) along the waterward side. Recommend removing vegetation along pipe alignment to conduct proper inspection of structure and appurtenances. (W. Wylie - DWR UCIP)
FIELD_STRUCT_DESC: 24-inch corrugated metal gravity drainage pipe through the levee, 10 feet below the crown. Flap gate on the waterside (WS) end. Brass cap No. 90 bench mark (BM) on the headwall on the landside (LS). [Additional Reference(s): DWR Levee Log, 2002 (HLM 4.73), listed as a 24-inch corrugated metal pipe (CMP). USACE San Joaquin O&M Manual, Unit 601 Part 1 (SJR601.1), 1967, Revised 25 May 2011, (HLM 4.72), listed as a 24-inch CMP].
FS Date: 4/8/2014

Pipe, flapgate, and headwall on WS toe.

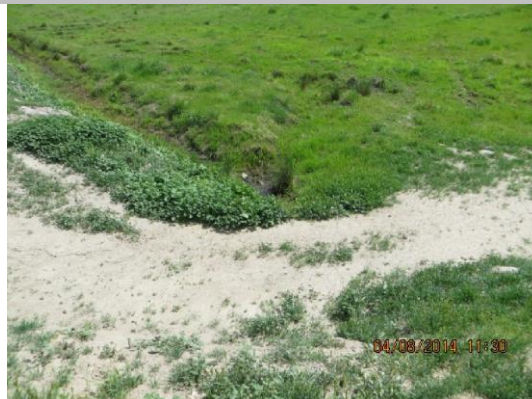
Photo 3 of 3 : UCIP_FA_2020_61841_60736.jpg

Pipe and concrete headwall on LS toe.

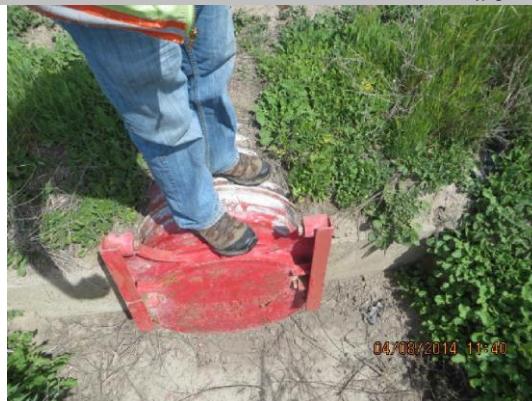
| DS_ID:19610 FS_ID:61842 EP_NO: N/A Repair Type: Non-Urgent EVAL Issue: Crossing Status: Found UCIP Comments: 04/08/2014 Non-functional -- sediment buildup against flapgate and inlet buried at landward side. (W. Wylie - DWR UCIP) FIELD_STRUCT_DESC: 24-inch corrugated metal gravity drainage pipe through the levee, 8 feet below the crown. Flap gate on the waterside (WS) end. Brass cap No. 90 bench mark (BM) on the headwall on the landside (LS). [Additional Reference(s): DWR Levee Log, 2002 (HLM 5.06), listed as a 24-inch corrugated metal pipe (CMP). USACE San Joaquin O&M Manual, Unit 601 Part 1 (SJR601.1), 1967, Revised 25 May 2011, (HLM 5.05), listed as a 24-inch CMP]. FS Date: 4/8/2014 | | | | | | |

Flapgate and headwall visible at WS toe.

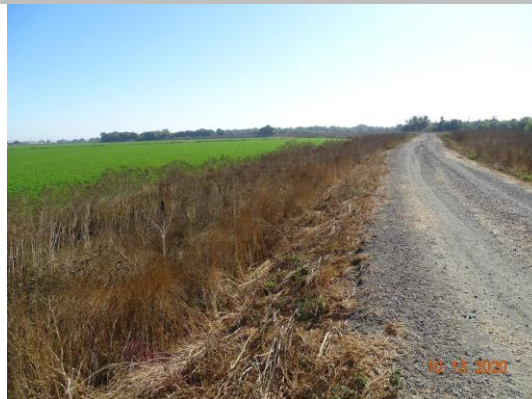
Photo 1 of 1 : FA_2020_NA0010_118_97_20201020_00269.jpg

View of the vegetation on the landside slope. (Fall 2020)

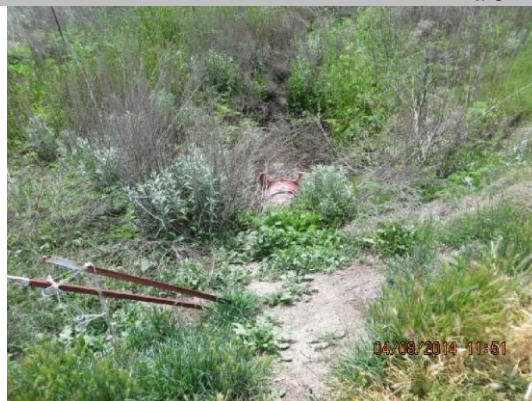
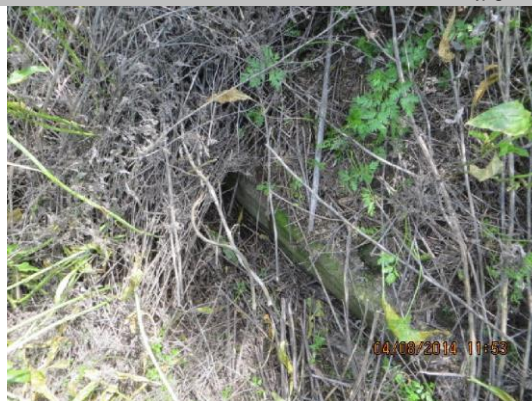
| DS_ID:19611 FS_ID:61843 EP_NO: N/A Repair Type: Non-Urgent EVAL Issue: Crossing Status: Found UCIP Comments: 04/08/2014 Dense vegetation limits the inspector's visibility to identify signs of pipe failure (leaks) along waterward and landward slopes. Recommend removing vegetation along pipe alignment to conduct proper inspection of structure and appurtenances. Landward side filled in with soil. Need to contact owner. If crossing is no longer used need to coordinate with CVFPB for proper abandonment. (W. Wylie - DWR UCIP) FIELD_STRUCT_DESC: 24-inch corrugated metal gravity drainage pipe through the levee, 8.6 feet below the crown. Flap gate on the waterside (WS) end. Brass cap No. 90 bench mark (BM) on the headwall on the landside (LS). [Additional Reference(s): DWR Levee Log, 2002 (HLM 5.96), listed as a 24-inch corrugated metal pipe (CMP). USACE San Joaquin O&M Manual, Unit 601 Part 1 (SJR601.1), 1967, Revised 25 May 2011, (HLM 5.95), listed as a 24-inch CMP]. FS Date: 4/8/2014 | | | | | | |

Pipe, concrete headwall, and flapgate visible on WS toe.

Top of concrete headwall just visible on LS toe.

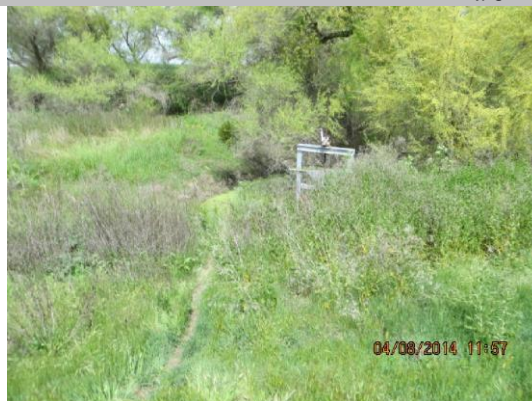
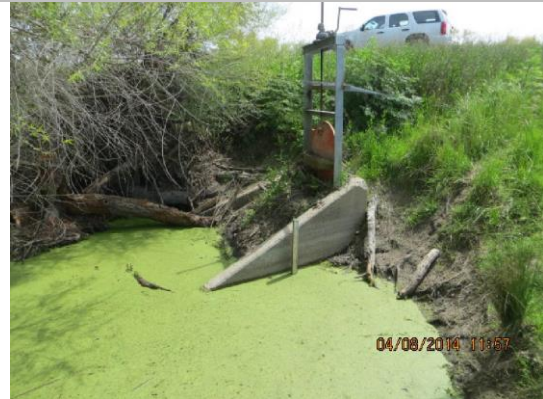
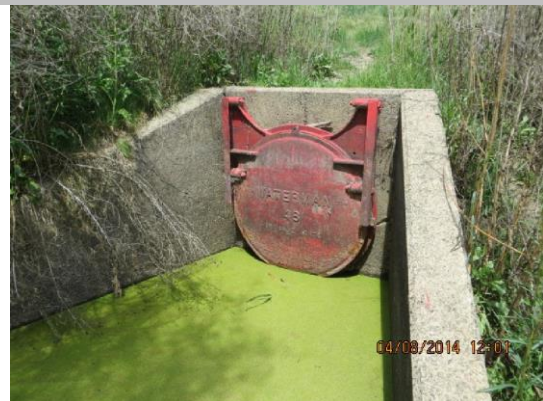
DS_ID:19612
 FS_ID:61844
 EP_NO: N/A
 Repair Type: Non-Urgent
 EVAL Issue:
 Crossing Status: Found
 UCIP Comments: 04/08/2014 Dense vegetation limits the inspector's visibility to identify signs of pipe failure (leaks) along waterward and landward slopes. Recommend removing vegetation along pipe alignment to conduct proper inspection of structure and appurtenances. Pipe completely blocked by soil on LS toe due to animal activity. Slide gate blocked open. (W. Wylie - DWR UCIP)
 FIELD_STRUCT_DESC: 48-inch corrugated metal gravity drainage pipe through the levee, 13.1 feet below the crown. Walkway to slide gate at the concrete headwall on the landside (LS) toe. Flap gate at the concrete headwall on the waterside (WS) toe. Brass cap No. 90 bench mark (BM) on the headwall on the LS. Pipe crosses the levee at an angle. [Additional Reference(s): DWR Levee Log, 2002 (HLM 6.13), listed as a 48-inch corrugated metal pipe (CMP). USACE San Joaquin O&M Manual, Unit 601 Part 1 (SJR601.1), 1967, Revised 25 May 2011, (HLM 6.13), listed as a 48-inch CMP].

Slidegate at LS toe.

Pipe, concrete headwall, slidegate, and metal walkway on LS toe.

Flapgate on concrete headwall at WS toe.

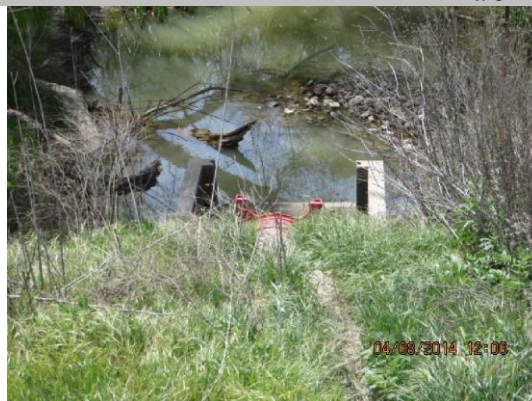
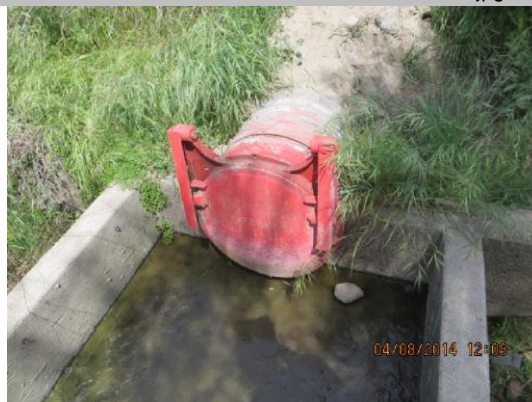
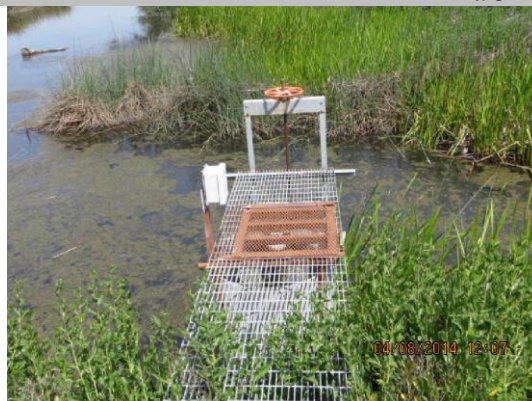
DS_ID:19613
 FS_ID:61845
 EP_NO: N/A
 Repair Type: Non-Urgent
 EVAL Issue:
 Crossing Status: Found
 UCIP Comments: 04/08/2014 Dense vegetation limits the inspector's visibility to identify signs of pipe failure (leaks) along the slope. Recommend removing vegetation along pipe alignment to conduct proper inspection of structure and appurtenances. (W. Wylie - DWR UCIP)
 FIELD_STRUCT_DESC: 24-inch corrugated metal gravity drainage pipe through the levee, 9.5 feet below the crown. Flap gate on the waterside (WS) end. Slide gate on the landside (LS) end next to a 48-inch concrete riser with walkway over the top. Brass cap No. 90 bench mark (BM) on the headwall on the LS. [Additional Reference(s): DWR Levee Log, 2002 (HLM 6.44), listed as a 24-inch corrugated metal pipe (CMP). USACE San Joaquin O&M Manual, Unit 601 Part 1 (SJR601.1), 1967, Revised 25 May 2011, (HLM 6.40), listed as a 24-inch CMP].
 FS Date: 4/8/2014

Pipe, flapgate, and concrete headwall on WS toe.

Metal walkway over concrete standpipe next to slide gate on LS toe.

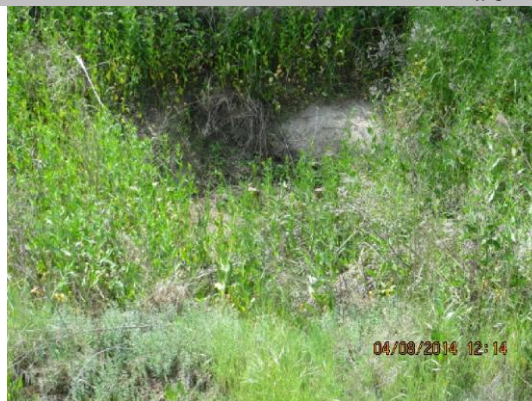
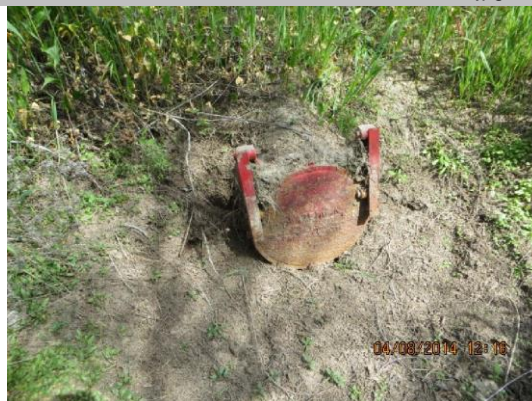
DS_ID:19614
 FS_ID:61846
 EP_NO: N/A
 Repair Type: Non-Urgent
 EVAL Issue:
 Crossing Status: Found
 UCIP Comments: 7/19/2016 Same as previous inspection. Outlet and inlet are under water. (O. Magana - DWR UCIP)4/08/2014 Flapgate blocked by sedimentation at WS toe. Dense vegetation limits the inspector's visibility to identify signs of pipe failure (leaks) along the slope. Recommend removing vegetation along pipe alignment to conduct proper inspection of structure and appurtenances. Also recommend clearing vegetation from both waterward and landward toe. (W. Wylie - DWR UCIP)
 FIELD_STRUCT_DESC: 24-inch corrugated metal gravity drainage pipe through the levee, 9.8 feet below the crown. Wooden fence around a 4-foot by 4-foot drop inlet on the landside (LS) toe. Flap gate on the waterside (WS) end. Brass cap No. 90 bench mark (BM) on the headwall on the LS. [Additional Reference(s): DWR Levee Log, 2002 (HLM 6.65), listed as a 24-inch corrugated metal pipe (CMP). USACE San Joaquin O&M Manual, Unit 601 Part 1 (SJR601.1), 1967, Revised 25 May 2011, (HLM 6.64), listed as a 24-inch CMP].

Pipe and flapgate visible on WS toe.

Pipe and flapgate visible at WS toe. Flapgate blocked by sedimentation on WS toe.

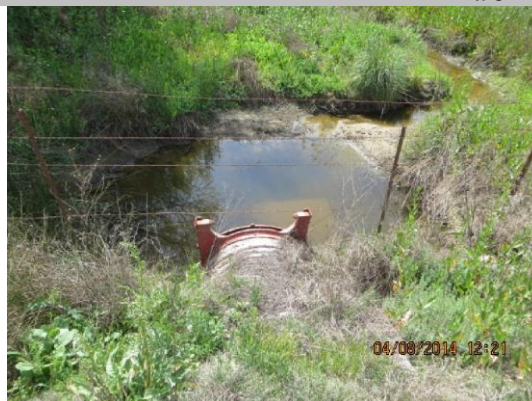
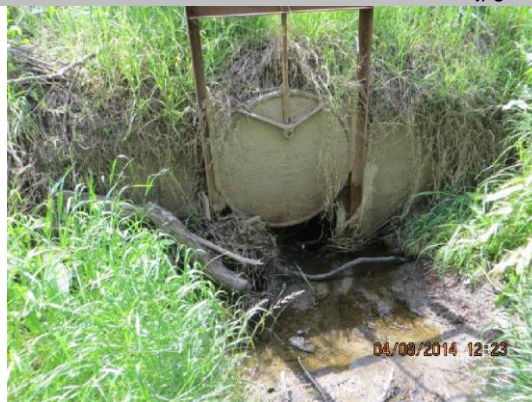
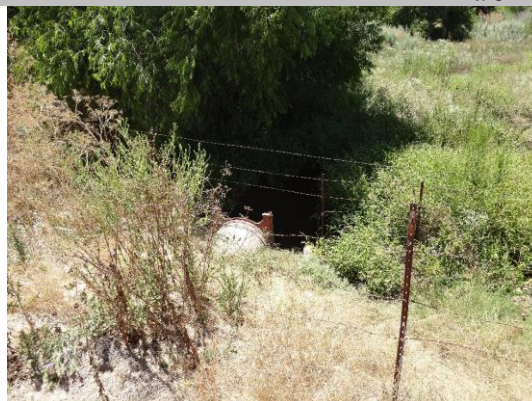
DS_ID:19615
FS_ID:61847
EP_NO: N/A
Repair Type: Non-Urgent
EVAL Issue:
Crossing Status: Found
UCIP Comments: 7/19/2016 Potential LS slope damage--difficult to determine due to dense vegetation. Limited access on WS toe due to wire fence. (O. Magana - DWR UCIP)4/08/2014 Slide gate blocked by debris at LS toe. Flapgate won't close because of debris. Dense vegetation limits the inspector's visibility to identify signs of pipe failure (leaks) along the slope. Recommend removing vegetation along pipe alignment to conduct proper inspection of structure and appurtenances. (W. Wylie - DWR UCIP)
FIELD_STRUCT_DESC: 36-inch corrugated metal gravity drainage pipe through the levee, 10.3 feet below the crown. Slide gate on the landside (LS) toe. Flap gate on the waterside (WS) end. Brass cap No. 90 bench mark (BM) on the headwall on the LS. [Additional Reference(s): DWR Levee Log, 2002 (HLM 6.90), listed as a 36-inch corrugated metal pipe (CMP). USACE San Joaquin O&M Manual, Unit 601 Part 1 (SJR601.1), 1967, Revised 25 May 2011, (HLM 6.90), listed as a 36-inch CMP].

Pipe, headwall, and flapgate on WS toe.

Pipe, concrete headwall, and slidegate on LS toe. Debris blocking closure of slidegate.

View of WS--fence limits access to flap gate.

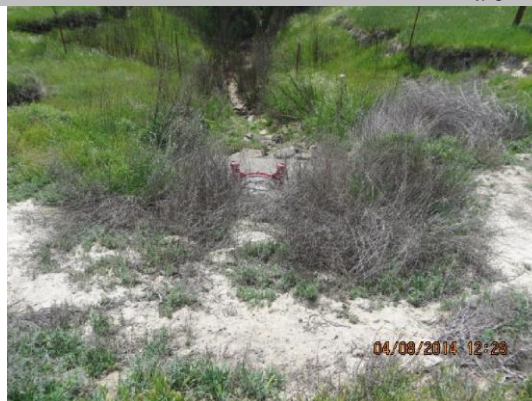
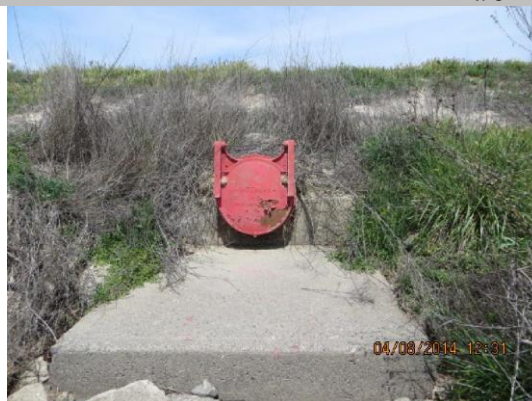
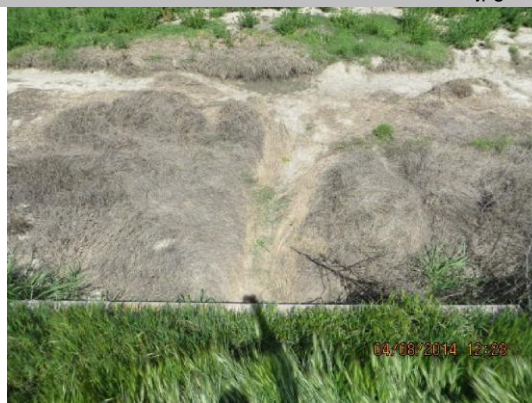
DS_ID:19616
 FS_ID:61848
 EP_NO: N/A
 Repair Type: Urgent
 EVAL Issue:
 Crossing Status: Found
 UCIP Comments: 11/01/2018 Pipe continues to corrode through. Voids (undermining) along pipe invert are visible from the LS. Potential undermining caused by erosion under concrete apron on the WS. Crossing remains Urgent due to the pipe failure. (O. Magana - DWR UCIP)04/08/2014 Pipe failing and corroded through at LS toe. Need to contact owner to determine status of crossing. Also dense vegetation limits the inspector's visibility to identify signs of pipe failure (leaks) along the landward slope. Recommend removing vegetation along pipe alignment to conduct proper inspection of structure. (W. Wylie - DWR UCIP)
 FIELD_STRUCT_DESC: 24-inch corrugated metal gravity drainage pipe through the levee, 5.1 feet below the crown. Flap gate on the waterside (WS) end. Brass cap No. 90 bench mark (BM) on the headwall on the landside (LS). [Additional Reference(s): DWR Levee Log, 2002 (HLM 7.22), listed as a 24-inch corrugated metal pipe (CMP). USACE San Joaquin O&M Manual, Unit 601 Part 1 (SJR601.1), 1967, Revised 25 May 2011, (HLM 7.21), listed as a 24-inch CMP].

Pipe, concrete headwall, and flapgate on WS toe.

Flapgate and concrete headwall on WS toe.

Pipe and Concrete headwall visible on LS toe.
