Flood Control Project Maintenance Levee Inspections

Fall 2020 Levee Maintenance Deficiency Summary Report

San Joaquin River Basin

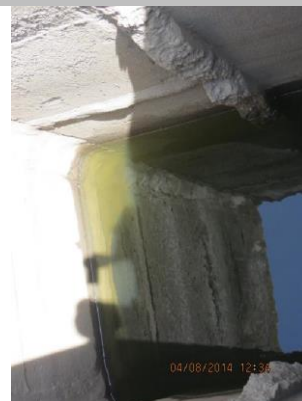
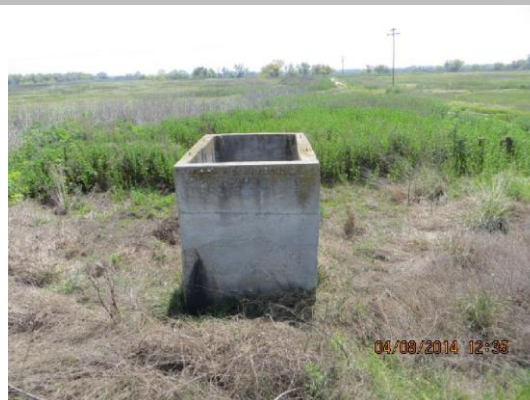
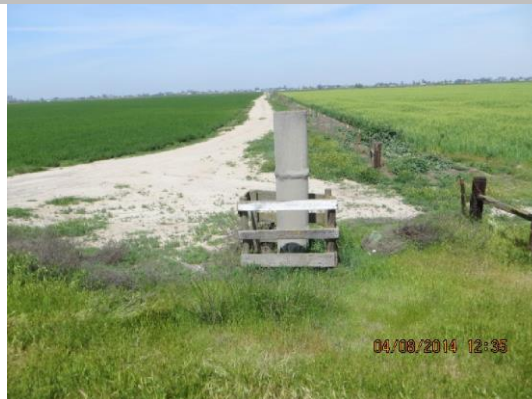
| DS_ID:19617 FS_ID:61849 EP_NO: 4425 Repair Type: Non-Urgent EVAL Issue: Crossing Status: Found UCIP Comments: 04/08/2014 Recommend contacting owner to determine status of crossing. No pump was found on waterward side (riverbank). If crossing is no longer used need to coordinate with CVFPB for proper abandonment. (W. Wylie - DWR UCIP) FIELD_STRUCT_DESC: 24-inch concrete encased steel irrigation discharge pipe through the levee, 13.6 feet below the crown. Pipe encased in 6-inches of concrete through the levee. 5-foot by 7-foot concrete distribution box on the waterside (WS). 20-inch concrete standpipe at the landside (LS) toe. Pump on the riverbank, accessible by walkway platform, pump not found. Concrete cutoff walls around pipe in line with the levee shoulders. Pipe extends to 36-inch concrete pipes on both sides of the levee. (Plans to install an irrigation pipeline through the levee authorized under Permit No. 4425, 1964 - James J. Stevinson, a Corporation). [Additional Reference(s): DWR Levee Log, 2002 (HLM 7.33), listed as a 24-inch pipe]. FS Date: 4/8/2014 | | | | | |

Pipe visible under water in concrete box riser on WS toe.

5'X7' concrete box riser on WS toe.

20-inch concrete standpipe off LS toe.

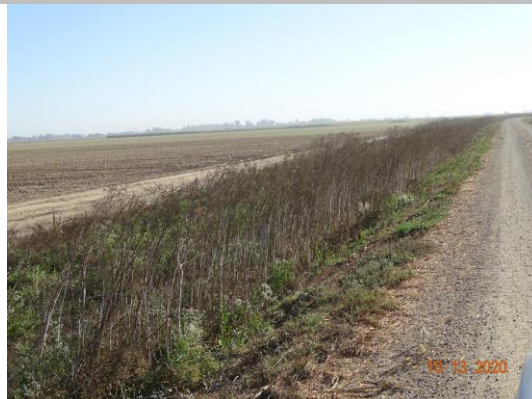
Photo 1 of 1 : FA_2020_NA0010_118_98_20201020_00270.jpg

View of the landside slope looking upstream. (Fall 2020)

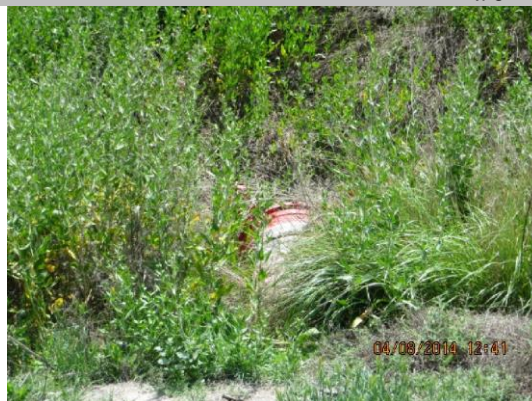
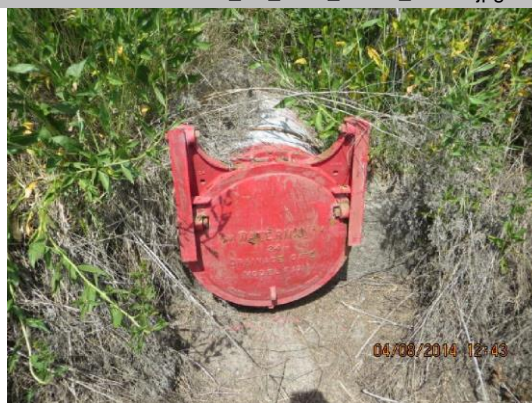
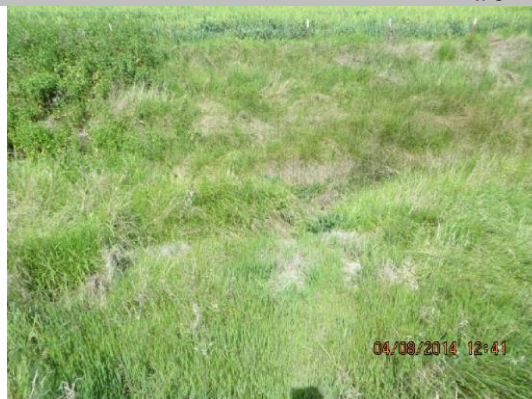
DS_ID:19618
FS_ID:61850
EP_NO: N/A
Repair Type: Non-Urgent
EVAL Issue:
Crossing Status: Found
UCIP Comments: 04/08/2014 Dense vegetation limits the inspector's visibility to identify signs of pipe failure (leaks) along the slope. Recommend removing vegetation along pipe alignment to conduct proper inspection of structure and appurtenances. (W. Wylie - DWR UCIP)
FIELD_STRUCT_DESC: 24-inch corrugated metal gravity drainage pipe through the levee, 8 feet below the crown. Flap gate on the waterside (WS) end. Brass cap No. 80 bench mark (BM) on the headwall on the landside (LS). [Additional Reference(s): DWR Levee Log, 2002 (HLM 7.46), listed as a corrugated metal pipe (CMP). USACE San Joaquin O&M Manual, Unit 601 Part 1 (SJR601.1), 1967, Revised 25 May 2011, (HLM 7.46), listed as a 24-inch CMP].
FS Date: 4/8/2014

Pipe and flapgate visible on WS toe.

Concrete headwall and pipe visible off LS toe in heavy vegetation.

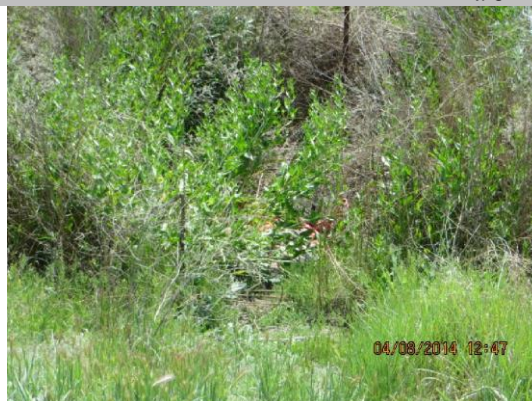
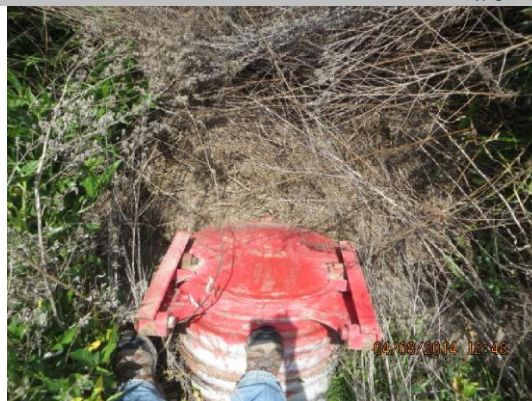
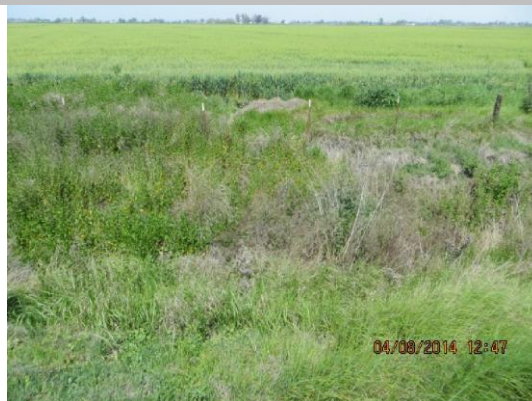
DS_ID:19619
 FS_ID:61851
 EP_NO: N/A
 Repair Type: Non-Urgent
 EVAL Issue:
 Crossing Status: Found
 UCIP Comments: 04/08/2014 Dense vegetation limits the inspector's visibility to identify signs of pipe failure (leaks) along the slope. Recommend removing vegetation along pipe alignment to conduct proper inspection of structure. (W. Wylie - DWR UCIP)
 FIELD_STRUCT_DESC: 24-inch corrugated metal gravity drainage pipe through the levee, 10 feet below the crown. Flap gate on the waterside (WS) end. Brass cap No. 80 bench mark (BM) on the headwall on the landside (LS). [Additional Reference(s): DWR Levee Log, 2002 (HLM 7.70), listed as a 24-inch corrugated metal pipe (CMP). USACE San Joaquin O&M Manual, Unit 601 Part 1 (SJR601.1), 1967, Revised 25 May 2011, (HLM 7.69), listed as a 24-inch CMP].
 FS Date: 4/8/2014

Flapgate and headwall at WS toe. Heavy vegetation on slopes.

Flapgate and headwall at WS toe.

Concrete headwall at LS toe. Heavy vegetation on both slopes.

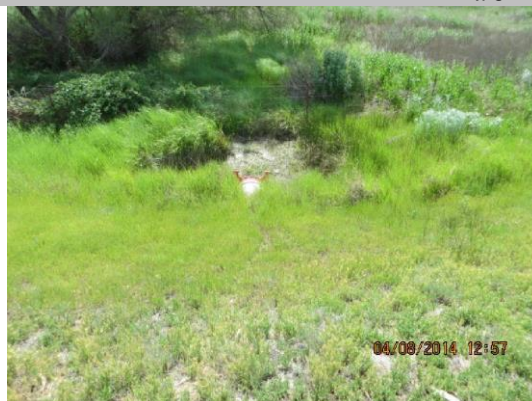
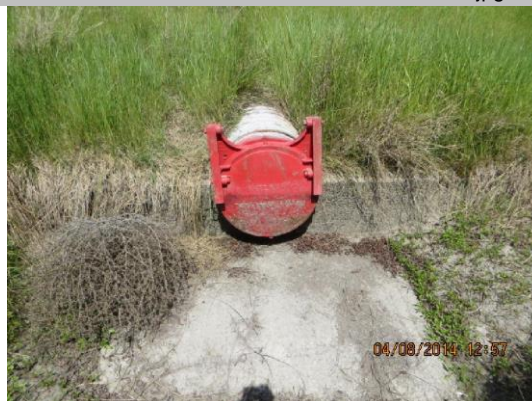
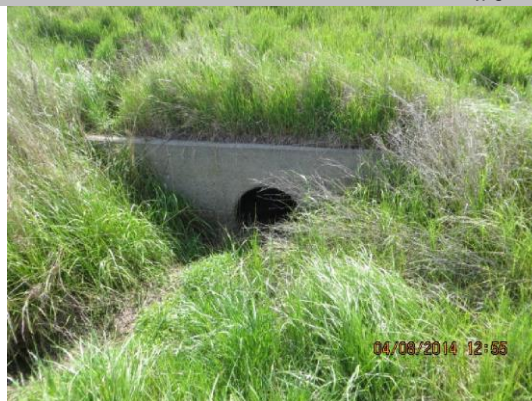
DS_ID:19620
FS_ID:61852
EP_NO: N/A
Repair Type: Non-Urgent
EVAL Issue:
Crossing Status: Found
UCIP Comments: 04/09/2014 Dense vegetation limits the inspector's visibility to identify signs of pipe failure (leaks) along the slope. Recommend removing vegetation along pipe alignment to conduct proper inspection of structure. (W. Wylie - DWR UCIP)
FIELD_STRUCT_DESC: 24-inch corrugated metal gravity drainage pipe through the levee, 8 feet below the crown. Flap gate on the waterside (WS) end. Brass cap No. 80 bench mark (BM) on the headwall on the landside (LS). [Additional Reference(s): DWR Levee Log, 2002 (HLM 8.09), listed as a 24-inch corrugated metal pipe (CMP). USACE San Joaquin O&M Manual, Unit 601 Part 1 (SJR601.1), 1967, Revised 25 May 2011, (HLM 8.07), listed as a 24-inch CMP].
FS Date: 4/9/2014

Pipe, Headwall, and flapgate at WS toe.

Pipe and concrete headwall on LS toe.

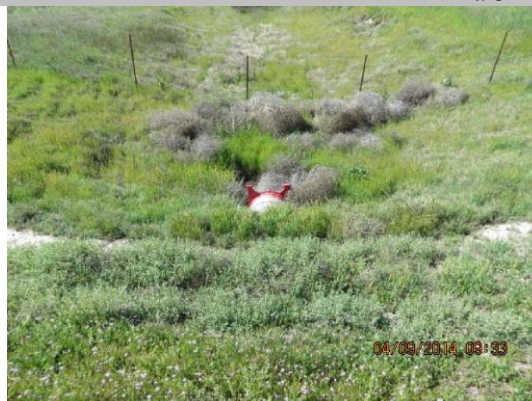
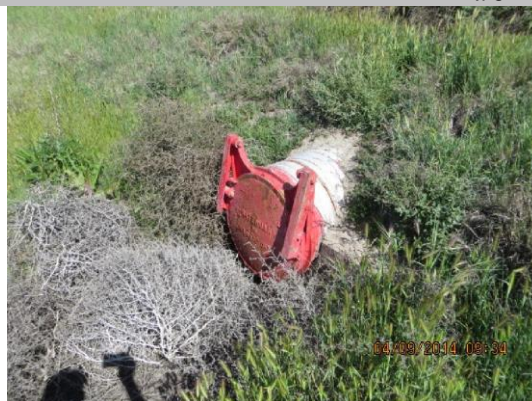
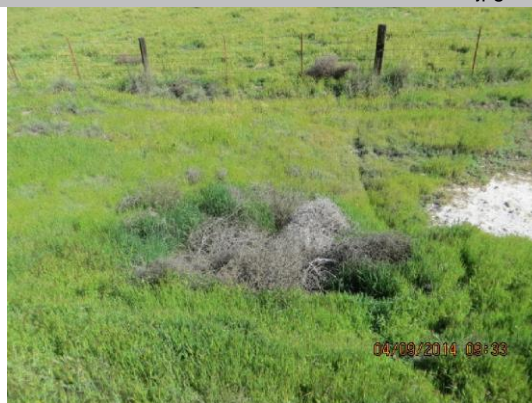
DS_ID:19621
 FS_ID:61853
 EP_NO: N/A
 Repair Type: Non-Urgent
 EVAL Issue:
 Crossing Status: Found
 UCIP Comments: 04/09/2014 Dense vegetation limits the inspector's visibility to identify signs of pipe failure (leaks) along the slope. Recommend removing vegetation along pipe alignment to conduct proper inspection of structure. Sediment buildup at landward toe. (W. Wylie - DWR UCIP)
 FIELD_STRUCT_DESC: 24-inch corrugated metal gravity drainage pipe through the levee, 9.5 feet below the crown. Flap gate on the waterside (WS) end. Brass cap No. 80 bench mark (BM) on the headwall on the landside (LS). [Additional Reference(s): DWR Levee Log, 2002 (HLM 8.43), listed as a 24-inch corrugated metal pipe (CMP). USACE San Joaquin O&M Manual, Unit 601 Part 1 (SJR601.1), 1967, Revised 25 May 2011, (HLM 8.41), listed as a 24-inch CMP].
 FS Date: 4/9/2014

Concrete headwall, pipe, and flapgate at WS toe.

Pipe and concrete headwall at LS toe. Note heavy vegetation.

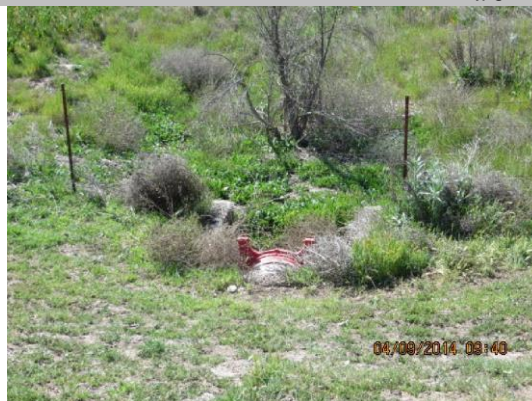
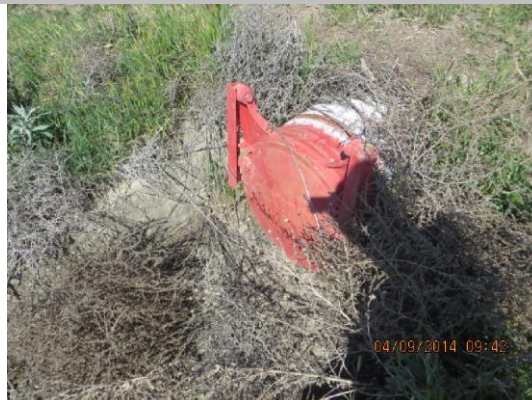
Photo 1 of 3 : UCIP_FA_2020_61854_60854.jpg

| DS_ID:19622 FS_ID:61854 EP_NO: N/A Repair Type: No Action Needed EVAL Issue: Crossing Status: Found UCIP Comments: FIELD_STRUCT_DESC: 24-inch corrugated metal gravity drainage pipe through the levee, 9 feet below the crown. Flap gate on the waterside (WS) end. Brass cap No. 80 bench mark (BM) on the headwall on the landside (LS). [Additional Reference(s): DWR Levee Log, 2002 (HLM 8.62), listed as a 24-inch corrugated metal pipe (CMP). USACE San Joaquin O&M Manual, Unit 601 Part 1 (SJR601.1), 1967, Revised 25 May 2011, (HLM 8.61), listed as a 24-inch CMP]. FS Date: 4/9/2014 | | | | | | |

Pipe, Flapgate, and headwall on WS toe.

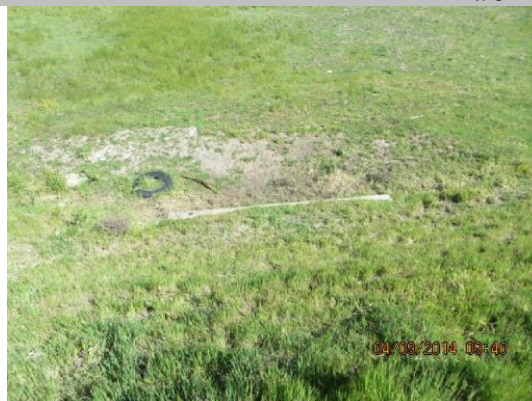
Photo 3 of 3 : UCIP_FA_2020_61854_60853.jpg

Pipe and headwall at LS toe.

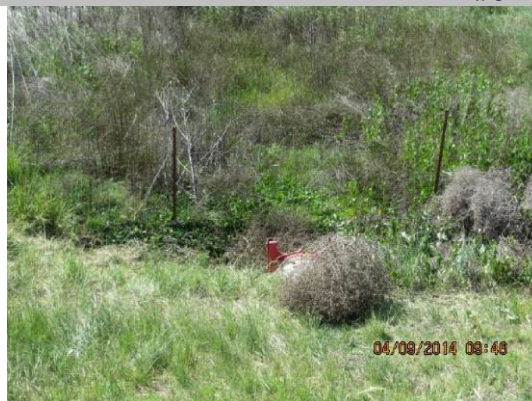
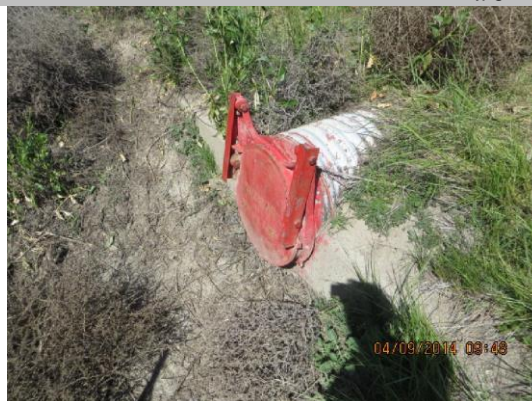
Photo 1 of 3 : UCIP_FA_2020_61855_60859.jpg

DS_ID:19623
 FS_ID:61855
 EP_NO: N/A
 Repair Type: Non-Urgent
 EVAL Issue:
 Crossing Status: Found
 UCIP Comments: 04/09/2014 Dense vegetation limits the inspector's visibility to identify signs of pipe failure (leaks) along the slope. Recommend removing vegetation along pipe alignment to conduct proper inspection of structure. (W. Wylie - DWR UCIP)
 FIELD_STRUCT_DESC: 24-inch corrugated metal gravity drainage pipe through the levee, 9.1 feet below the crown. Flap gate on the waterside (WS) end. Brass cap No. 80 bench mark (BM) on the headwall on the landside (LS). [Additional Reference(s): DWR Levee Log, 2002 (HLM 8.95), listed as a 24-inch corrugated metal pipe (CMP). USACE San Joaquin O&M, Unit 601 Part 1 (SJR601.1), 1967, Revised 25 May 2011, (HLM 8.93), listed as a 24-inch CMP].
 FS Date: 4/9/2014

Pipe, flapgate, and headwall on WS toe.

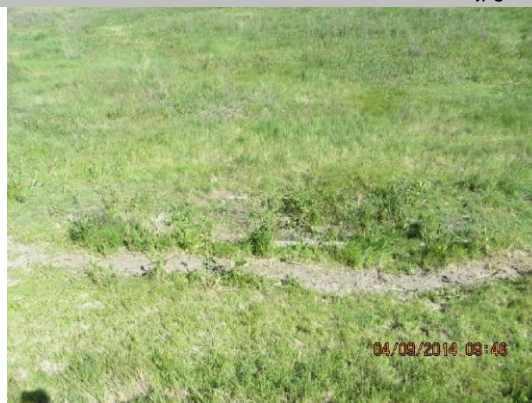
Photo 3 of 3 : UCIP_FA_2020_61855_60858.jpg

Pipe and headwall visible on LS toe.

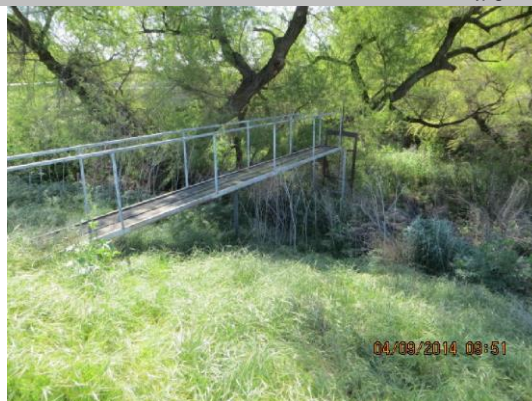
Photo 1 of 3 : UCIP_FA_2020_61856_60864.jpg

DS_ID:19624
FS_ID:61856
EP_NO: 12156
Repair Type: Urgent
EVAL Issue:
Crossing Status: Found
UCIP Comments: 11/01/2018 Dense vegetation prevented a full inspection of this crossing. Assumed crossing remains the same as the 2016 inspection. Crossing remains Urgent due to signs of pipe being rusted through visible from the WS. Need to contact owner to clear the dense vegetation on both the WS and the LS to be able to perform proper inspection of crossing. (O. Magana - DWR UCIP)7/19/2016 same as previous inspection--pipe rusted through. Sediment visible inside LS pipe; walkway wood panels have dry rot and appears to be unsafe to use. (O. Magana - DWR UCIP)4/09/2014 Slide gate rusted through and open on WS toe. Inlet appears to be obscured or covered in soil at LS toe. Also dense vegetation on waterward and landward sides. Need to contact owner to contact CVFPB to address issue. (W. Wylie - DWR UCIP)

Metal walkway to slidegate operator on WS toe.

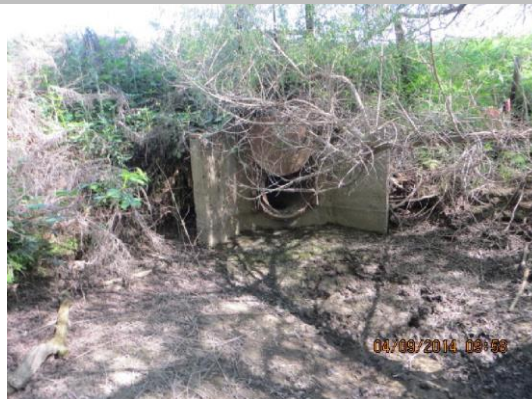
Photo 2 of 3 : UCIP_FA_2020_61856_60862.jpg

Slidegate and headwall at WS toe.

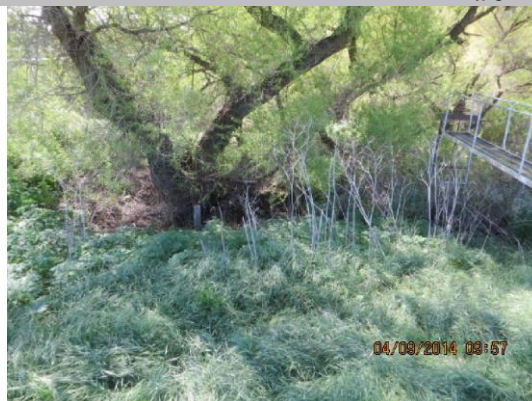
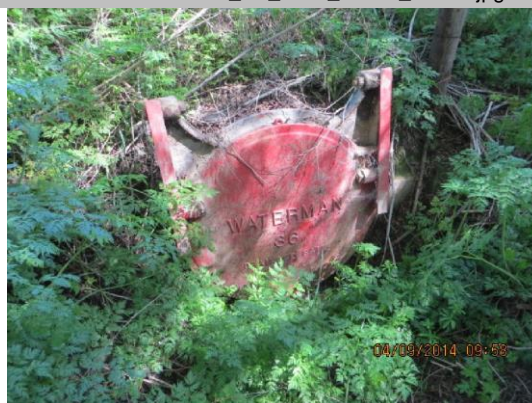
Photo 1 of 3 : UCIP_FA_2020_61857_60870.jpg

DS_ID:19625
FS_ID:61857
EP_NO: N/A
Repair Type: Non-Urgent
EVAL Issue:
Crossing Status: Found
UCIP Comments: 04/09/2014 Dense vegetation limits the inspector's visibility to identify signs of pipe failure (leaks) along the slope. Recommend removing vegetation along pipe alignment to conduct proper inspection of structure. Some sediment buildup in pipe. (W. Wylie - DWR UCIP)
FIELD_STRUCT_DESC: 36-inch corrugated metal gravity drainage pipe through the levee, 10 feet below the crown. Flap gate on the waterside (WS) end. Brass cap No. 80 bench mark (BM) on the headwall on the landside (LS). [Additional Reference(s): DWR Levee Log, 2002 (HLM 9.01), listed as a 36-inch corrugated metal pipe (CMP). USACE San Joaquin O&M Manual, Unit 601 Part 1 (SJR601.1), 1967, Revised 25 May 2011, (HLM 9.00), listed as a 36-inch CMP].
FS Date: 4/9/2014

Pipe and flapgate visible on WS toe.

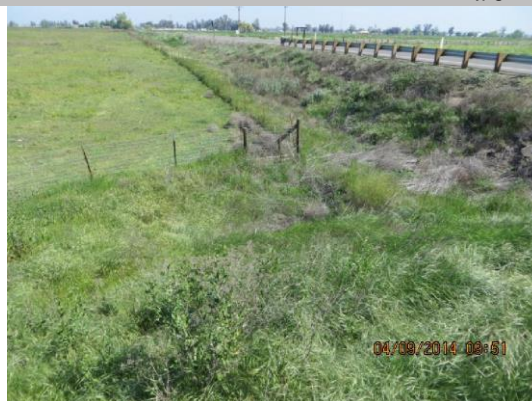
Photo 3 of 3 : UCIP_FA_2020_61857_60868.jpg

Pipe and headwall visible on LS toe.

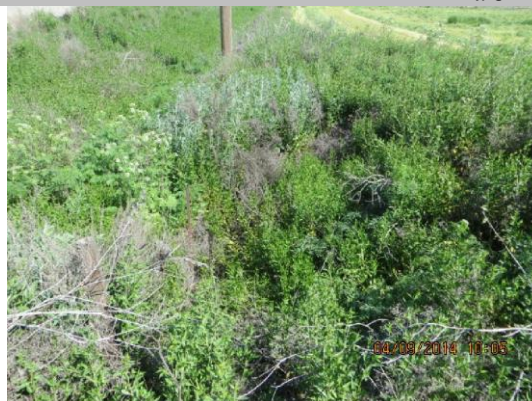
Photo 1 of 2 : UCIP_FA_2020_61858_60872.jpg

DS_ID:19626
 FS_ID:61858
 EP_NO: N/A
 Repair Type: Non-Urgent
 EVAL Issue:
 Crossing Status: Found
 UCIP Comments: 04/09/2014 Dense vegetation limits the inspector's visibility to identify signs of pipe failure (leaks) along the slope. Recommend removing vegetation along pipe alignment to conduct proper inspection of structure. (W. Wylie - DWR UCIP)
 FIELD_STRUCT_DESC: 24-inch corrugated metal gravity drainage pipe through the levee, 10 feet below the crown. Flap gate on the waterside (WS) end. Brass cap No. 80 bench mark (BM) on the headwall on the landside (LS). [Additional Reference(s): DWR Levee Log, 2002 (HLM 9.03), listed as a 24-inch corrugated metal pipe (CMP). USACE San Joaquin O&M Manual, Unit 601 Part 1 (SJR601.1), 1967, Revised 25 May 2011, (HLM 9.03), listed as a 24-inch CMP].
 FS Date: 4/9/2014

Heavy vegetation on LS toe.

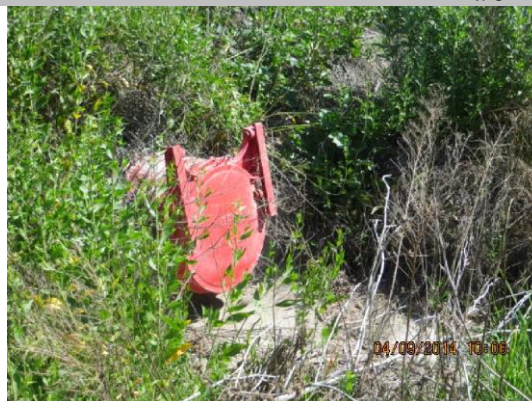
Photo 2 of 2 : UCIP_FA_2020_61858_60871.jpg

Pipe, concrete headwall, and flapgate at WS toe.

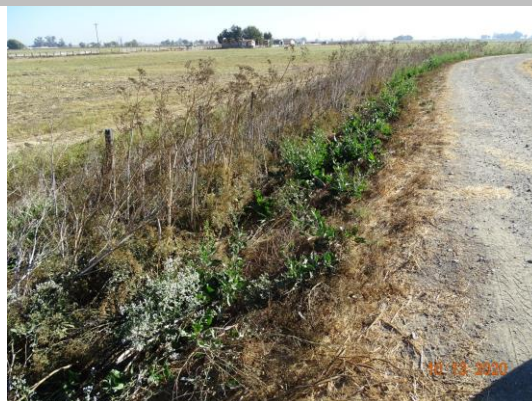
Photo 1 of 1 : FA_2020_NA0010_118_100_20201020_00271.jpg

Looking upstream at vegetation along the landside slope. (Fall 2020)

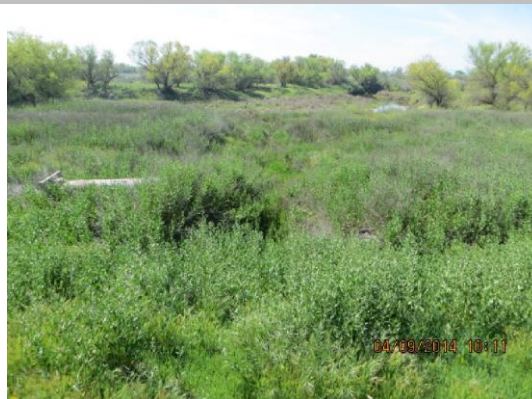
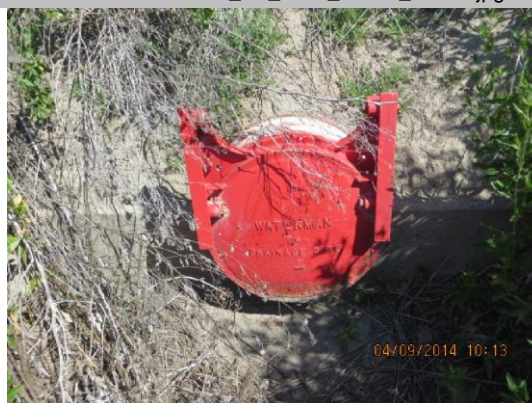
Photo 1 of 3 : UCIP_FA_2020_61863_60875.jpg

DS_ID:19627
FS_ID:61863
EP_NO: N/A
Repair Type: Non-Urgent
EVAL Issue:
Crossing Status: Found
UCIP Comments: 04/09/2014 Dense vegetation limits the inspector's visibility to identify signs of pipe failure (leaks) along the slope. Recommend removing vegetation along pipe alignment to conduct proper inspection of structure. (W. Wylie - DWR UCIP)
FIELD_STRUCT_DESC: 24-inch corrugated metal gravity drainage pipe through the levee, 8.6 feet below the crown. Concrete drop inlet at the landside (LS) toe. Flap gate on the waterside (WS) end. Brass cap No. 80 bench mark (BM) on the headwall on the LS. [Additional Reference(s): DWR Levee Log, 2002 (HLM 9.39), listed as a 24-inch corrugated metal pipe (CMP). USACE San Joaquin O&M Manual, Unit 601 Part 1 (SJR601.1), 1967, Revised 25 May 2011, (HLM 9.37), listed as 24-inch CMP].
FS Date: 4/9/2014

Pipe and flapgate on WS toe.

Headwall, Pipe, and flapgate on WS toe.

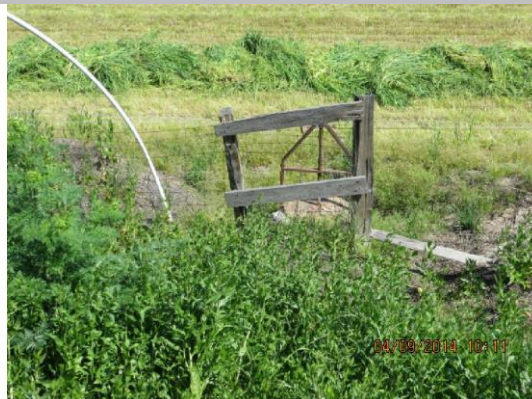
Photo 3 of 3 : UCIP_FA_2020_61863_60874.jpg

Concrete drop-inlet installed on pipe at LS toe.

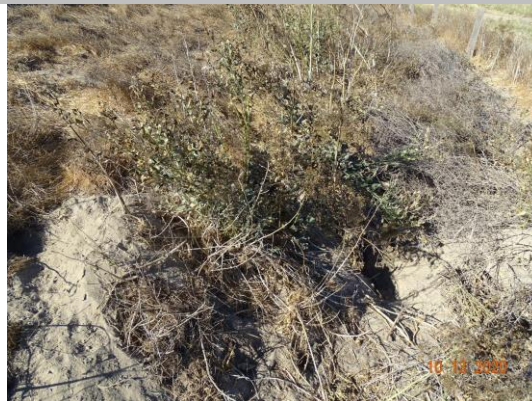
Photo 1 of 1 : FA_2020_NA0010_118_101_20201020_00272.jpg

Rodent burrows in the landside slope. (Fall 2020)

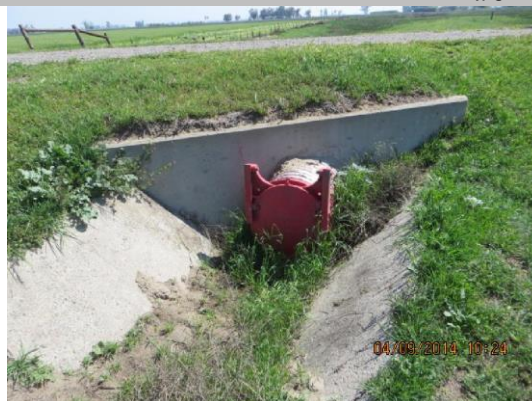
Photo 1 of 1 : UCIP_FA_2020_61860_60880.jpg

| DS_ID:19628 FS_ID:61860 EP_NO: N/A Repair Type: No Action Needed EVAL Issue: Crossing Status: Found UCIP Comments: FIELD_STRUCT_DESC: 24-inch corrugated metal gravity drainage pipe through the levee, 4.5 feet below the crown. Flap gate on the waterside (WS) end. Brass cap No. 80 bench mark (BM) on the headwall on the landside (LS). [Additional Reference(s): DWR Levee Log, 2002 (HLM 9.68), listed as a 24-inch corrugated metal pipe (CMP). USACE San Joaquin O&M Manual, Unit 601 Part 1 (SJR601.1), 1967, Revised 25 May 2011, (HLM 9.67), listed as a 24-inch CMP]. FS Date: 4/9/2014 | | | | | | |

Pipe, flapgate, and headwall visible on WS toe.

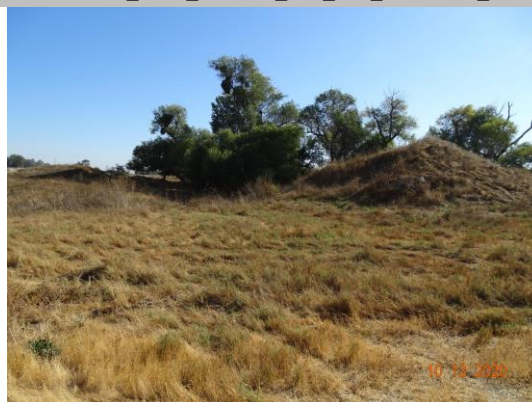
Photo 1 of 1 : FA_2020_NA0010_118_112_20201020_00273.jpg

| Landowner degraded levee in the 1970's because water on LS was flooding his property. Landowner has prevented efforts to restore levee. LMA has stated that no water from the waterside of the levee has ever backed up through the degraded levee and caused flooding. | | | | | |

Looking east at the levee breach. (Fall 2020)

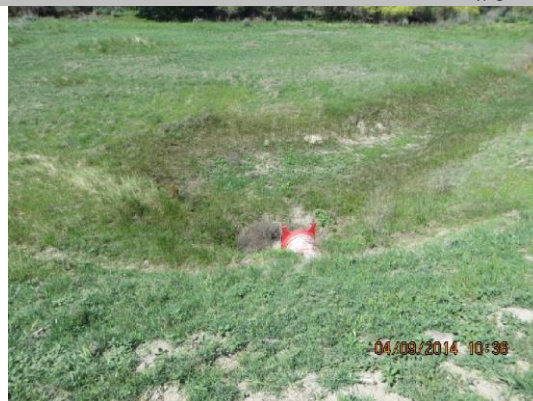
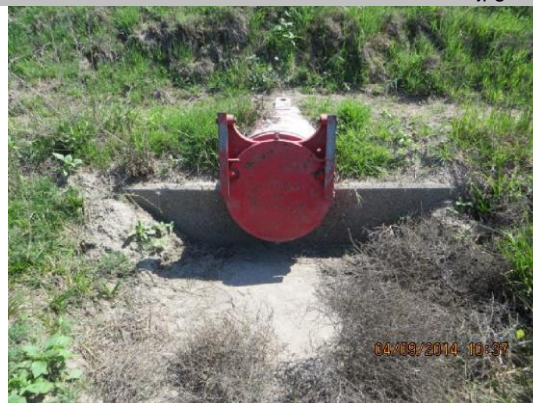
Photo 1 of 3 : UCIP_FA_2020_61865_60884.jpg

DS_ID:19629
FS_ID:61865
EP_NO: N/A
Repair Type: Non-Urgent
EVAL Issue:
Crossing Status: Found
UCIP Comments: 04/09/2014 Dense vegetation blocks waterward and landward toes Recommend removing vegetation from both toes. Also sediment buildup in pipe visible from landward side. (W. Wylie - UCIP DMP)
FIELD_STRUCT_DESC: 24-inch corrugated metal gravity drainage pipe through the levee, 9 feet below the crown. Flap gate on the waterside (WS) end. Brass cap No. 69 bench mark (BM) on the headwall on the landside (LS). [Additional Reference(s): DWR Levee Log, 2002 (HLM 10.24), listed as a 24-inch corrugated metal pipe (CMP). USACE San Joaquin O&M Manual, Unit 601 Part 1 (SJR601.1), 1967, Revised 25 May 2011, (HLM 10.23), listed as a 24-inch CMP].
FS Date: 4/9/2014

Pipe, headwall, and flapgate on WS toe.

Pipe, headwall, and flapgate at WS toe.

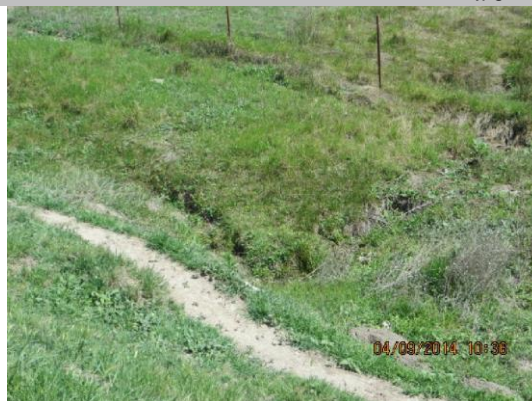
Photo 3 of 3 : UCIP_FA_2020_61865_60885.jpg

Pipe and headwall at LS toe.

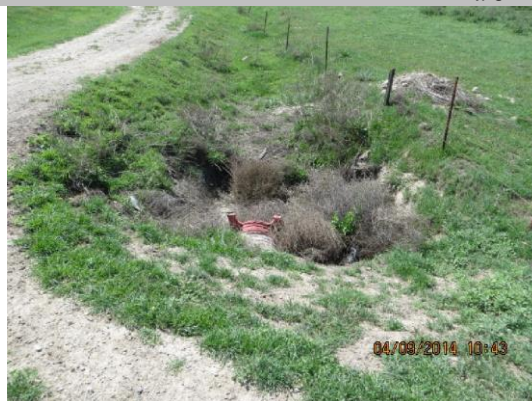
Photo 1 of 3 : UCIP_FA_2020_61866_60890.jpg

DS_ID:19630
 FS_ID:61866
 EP_NO: N/A
 Repair Type: No Action Needed
 EVAL Issue:
 Crossing Status: Found
 UCIP Comments:
 FIELD_STRUCT_DESC: 24-inch corrugated metal gravity drainage pipe through the levee, 7 feet below the crown. Flap gate on the waterside (WS) end. Brass cap No. 68 bench mark (BM) on the headwall on the landside (LS). [Additional Reference(s): DWR Levee Log, 2002 (HLM 10.73), listed as a 24-inch corrugated metal pipe (CMP). USACE San Joaquin O&M Manual, Unit 601 Part 1 (SJR601.1), 1967, Revised 25 May 2011, (HLM 10.72), listed as a 24-inch CMP].
 FS Date: 4/9/2014

Pipe and flapgate on WS toe.

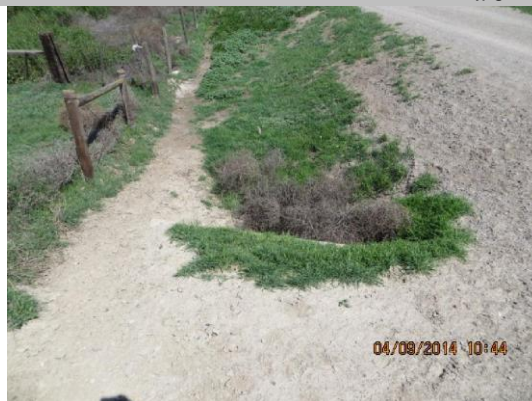
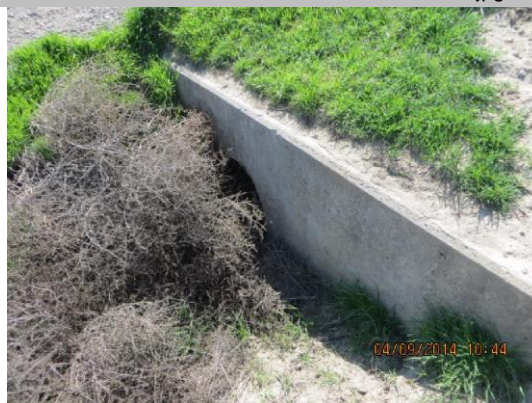
Photo 2 of 3 : UCIP_FA_2020_61866_60889.jpg

Pipe and headwall on LS toe.

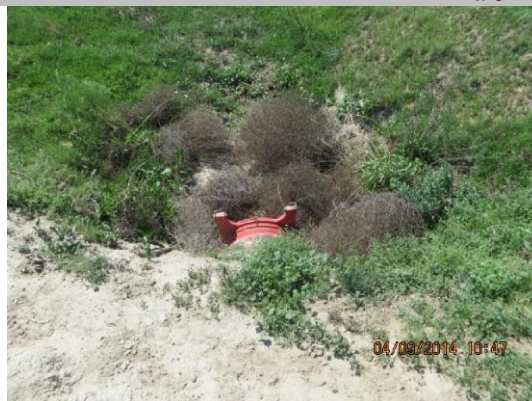
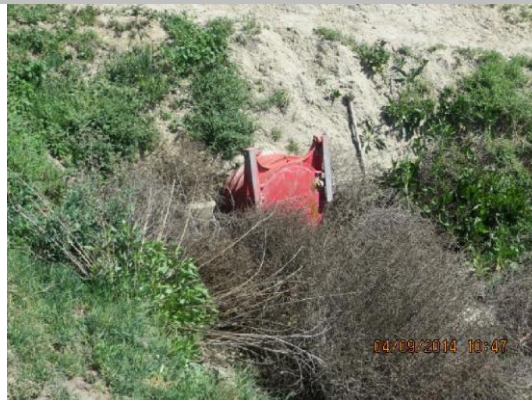
Photo 1 of 3 : UCIP_FA_2020_61867_60894.jpg

| DS_ID:19631 FS_ID:61867 EP_NO: N/A Repair Type: No Action Needed EVAL Issue: Crossing Status: Found UCIP Comments: FIELD_STRUCT_DESC: 24-inch corrugated metal gravity drainage pipe through the levee, 7 feet below the crown. Flap gate on the waterside (WS) end. Brass cap No. 67 bench mark (BM) on the headwall on the landside (LS). [Additional Reference(s): DWR Levee Log, 2002 (HLM 10.74), listed as a 24-inch corrugated metal pipe (CMP). USACE San Joaquin O&M Manual, Unit 601 Part 1 (SJR601.1), 1967, Revised 25 May 2011, (HLM 10.72), listed as a 24-inch CMP]. FS Date: 4/9/2014 | | | | | | |

Headwall, pipe, and flapgate on WS toe.

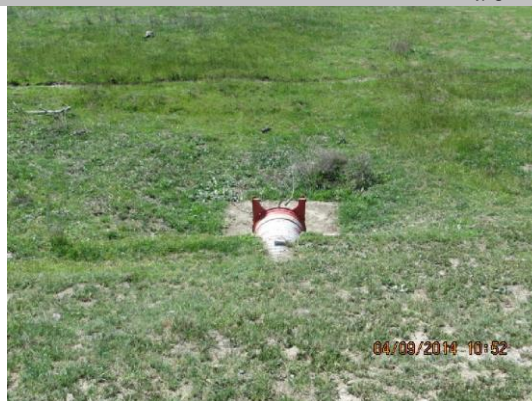
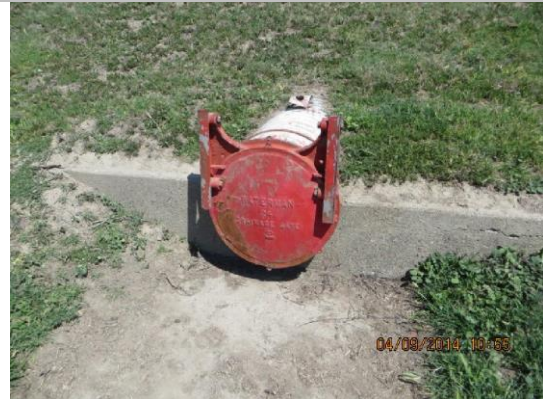
Photo 1 of 3 : UCIP_FA_2020_61868_60897.jpg

DS_ID:19632
 FS_ID:61868
 EP_NO: N/A
 Repair Type: Non-Urgent
 EVAL Issue:
 Crossing Status: Found
 UCIP Comments: 04/09/2014 Dense vegetation blocks landward headwall. Recommend removing excess vegetation on landward toe. (W. Wylie - DWR UCIP)
 FIELD_STRUCT_DESC: 24-inch corrugated metal gravity drainage pipe through the levee, 6 feet below the crown. Flap gate on the waterside (WS) end. Brass cap No. 66 bench mark (BM) on the headwall on the landside (LS). [Additional Reference(s): DWR Levee Log, 2002 (HLM 11.02), listed as a 24-inch corrugated metal pipe (CMP). USACE San Joaquin O&M Manual, Unit 601 Part 1 (SJR601.1), 1967, Revised 25 May 2011, (HLM 11.00), listed as a 24-inch CMP].
 FS Date: 4/9/2014

Pipe, headwall, and flapgate on WS toe.

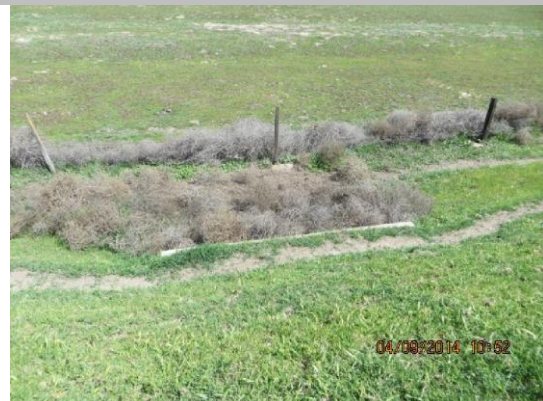
Photo 3 of 3 : UCIP_FA_2020_61868_60898.jpg

Pipe and headwall on LS toe.

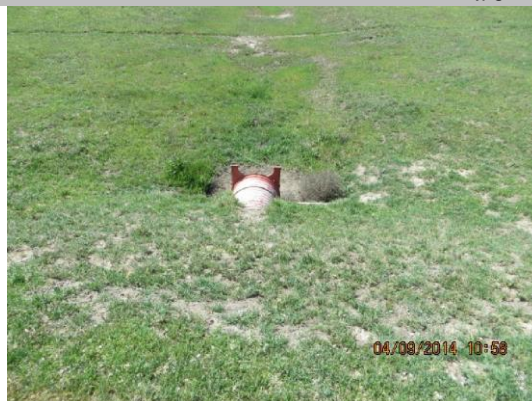
Photo 1 of 3 : UCIP_FA_2020_61869_60903.jpg

| DS_ID:19633 FS_ID:61869 EP_NO: N/A Repair Type: No Action Needed EVAL Issue: Crossing Status: Found UCIP Comments: FIELD_STRUCT_DESC: 24-inch corrugated metal gravity drainage pipe through the levee, 5 feet below the crown. Flap gate on the waterside (WS) end. Brass cap No. 65 bench mark (BM) on the headwall on the landside (LS). [Additional Reference(s): DWR Levee Log, 2002 (HLM 11.20), listed as a 24-inch corrugated metal pipe (CMP). USACE San Joaquin O&M Manual, Unit 601 Part 1 (SJR601.1), 1967, Revised 25 May 2011, (HLM 11.18), listed as a 24-inch CMP]. FS Date: 4/9/2014 | | | | | | |

Pipe, headwall, and flapgate on WS toe.

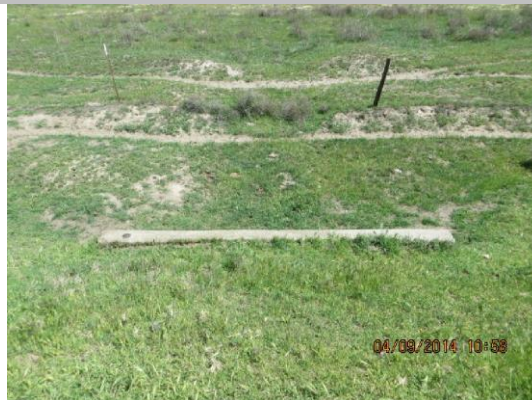
Photo 2 of 3 : UCIP_FA_2020_61869_60902.jpg

Pipe and headwall at LS toe.

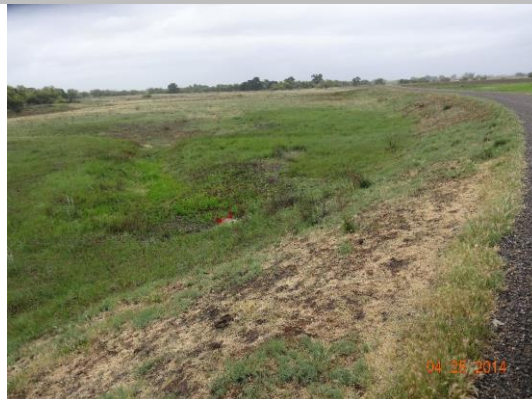
Photo 1 of 3 : UCIP_FA_2020_61870_65362.jpg

DS_ID:19634
FS_ID:61870
EP_NO: N/A
Repair Type: Non-Urgent
EVAL Issue:
Crossing Status: Found
UCIP Comments: 04/25/2014 Need to contact owner--landward side has been buried. It appears that soil was removed from levee toe, immediately upstream, and used to pile soil at landward side at crossing. (O. Magana - DWR UCIP)
FIELD_STRUCT_DESC: 24-inch corrugated metal gravity drainage pipe through the levee, 10 feet below the crown. Flap gate on the waterside (WS) end. Brass cap No. 62 bench mark (BM) on the headwall on the landside (LS). [Additional Reference(s): DWR Levee Log, 2002 (HLM 11.48), listed as a 24-inch corrugated metal pipe (CMP). USACE San Joaquin O&M Manual, Unit 601 Part 1 (SJR601.1), 1967, Revised 25 May 2011, (HLM 11.48), listed as a 24-inch CMP].
FS Date: 4/25/2014

View of waterward side.

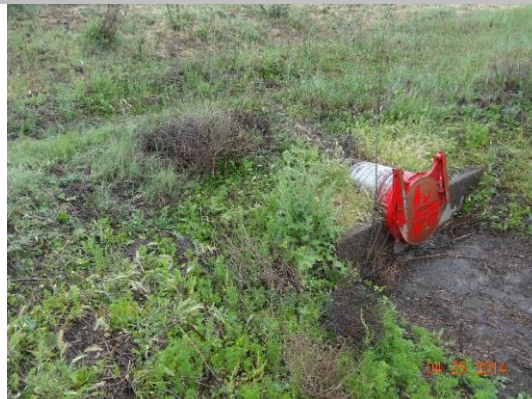
Photo 2 of 3 : UCIP_FA_2020_61870_65364.jpg

View of concrete headwall and flap gate visible on waterward side.

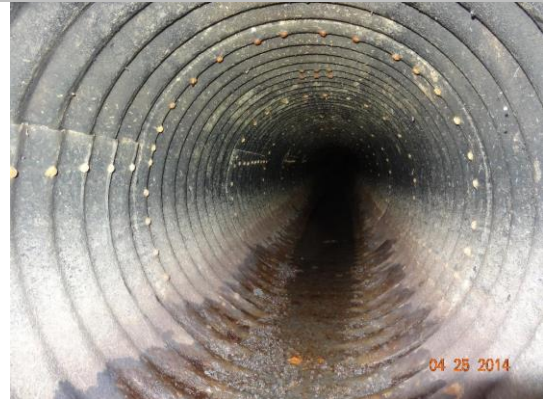
Photo 3 of 3 : UCIP_FA_2020_61870_65363.jpg

Inside view of pipe from waterward side.

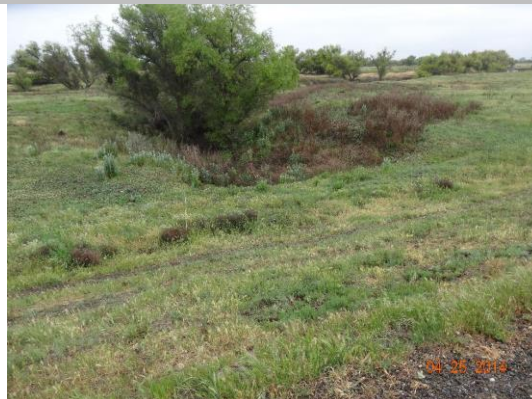
Photo 1 of 3 : UCIP_FA_2020_61871_65372.jpg

DS_ID:19635
FS_ID:61871
EP_NO: N/A
Repair Type: Non-Urgent
EVAL Issue:
Crossing Status: Found
UCIP Comments: 04/25/2014 Crossing is non-functional --landward side is buried. Debris found on landward side (channel). Dense vegetation found on waterward slope. Recommend contacting owner to determine status of crossing. If crossing is no longer used need to coordinate with CVFPB for proper abandonment. (O. Magana - DWR UCIP)
FIELD_STRUCT_DESC: 24-inch corrugated metal gravity drainage pipe through the levee, 17 feet below the crown. Flap gate on the waterside (WS) end. Brass cap No. 61 bench mark (BM) on the headwall on the landside (LS). [Additional Reference(s): DWR Levee Log, 2002 (HLM 11.77), listed as a 24-inch corrugated metal pipe (CMP). USACE San Joaquin O&M Manual, Unit 601 Part 1 (SJR601.1), 1967, Revised 25 May 2011, (HLM 11.76), listed as a 24-inch CMP].
FS Date: 4/25/2014

View of waterward side.

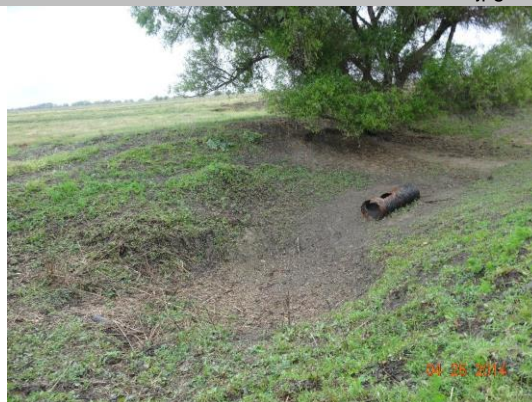
Photo 2 of 3 : UCIP_FA_2020_61871_65371.jpg

Landward side of crossing buried--damage pipe section visible on landward side.

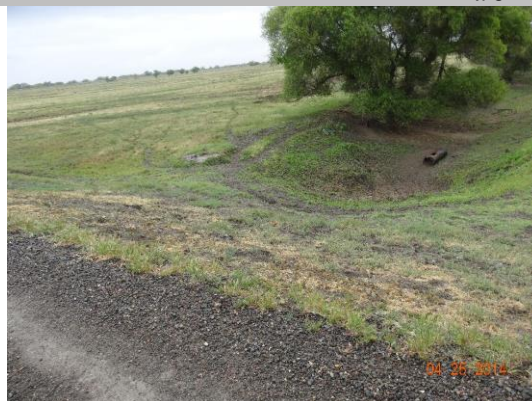
Photo 3 of 3 : UCIP_FA_2020_61871_65373.jpg

View of landward side.

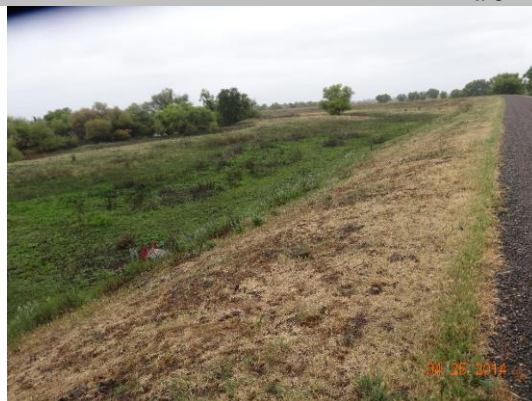
Photo 1 of 3 : UCIP_FA_2020_61873_65378.jpg

DS_ID:19636
 FS_ID:61873
 EP_NO: N/A
 Repair Type: Non-Urgent
 EVAL Issue:
 Crossing Status: Found
 UCIP Comments: 04/25/2014 Crossing is non-functional --landward side is buried. Dense vegetation found on waterward slope. Recommend contacting owner to determine status of crossing. If crossing is no longer used need to coordinate with CVFPB for proper abandonment. (O. Magana - DWR UCIP)
 FIELD_STRUCT_DESC: 24-inch corrugated metal gravity drainage pipe through the levee, 12.4 feet below the crown. Flap gate on the waterside (WS) end. Brass cap No. 60 bench mark (BM) on the headwall on the landside (LS). [Additional Reference(s): DWR Levee Log, 2002 (HLM 12.12), listed as a 24-inch corrugated metal pipe (CMP). USACE San Joaquin O&M Manual, Unit 601 Part 1 (SJR601.1), 1967, Revised 25 May 2011, (HLM 12.11), listed as a 24-inch CMP].
 FS Date: 4/25/2014

View of waterward side--flap gate visible on waterward toe.

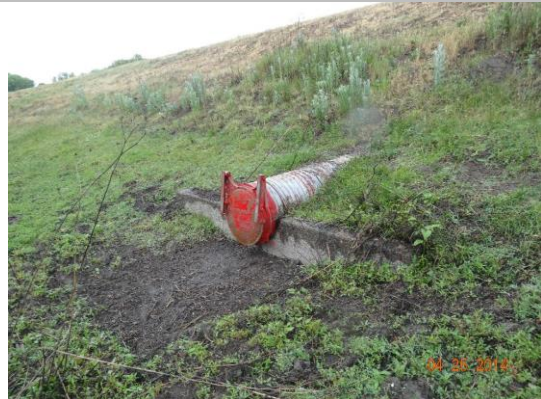
Photo 2 of 3 : UCIP_FA_2020_61873_65379.jpg

Flap gate and concrete headwall visible on waterward side.

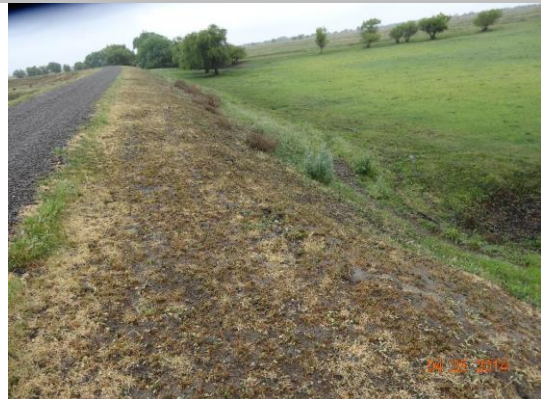
Photo 3 of 3 : UCIP_FA_2020_61873_65377.jpg

View of landward side.

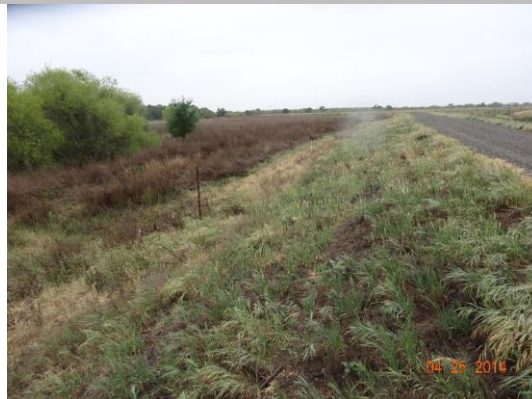
Photo 1 of 3 : UCIP_FA_2020_61874_65412.jpg

DS_ID:19637
FS_ID:61874
EP_NO: N/A
Repair Type: Non-Urgent
EVAL Issue:
Crossing Status: Found
UCIP Comments: 04/25/2014 Concrete headwall on landward side blocked by debris. Dense vegetation limits the inspector's visibility to identify signs of pipe failure (leaks) along the landward slope. Recommend removing vegetation along pipe alignment to conduct proper inspection of crossing. (O. Magana - DWR UCIP)
FIELD_STRUCT_DESC: 24-inch corrugated metal gravity drainage pipe through the levee, 9.5 feet below the crown. Flap gate on the waterside (WS) end. Brass cap No. 60 bench mark (BM) on the headwall on the landside (LS). [Additional Reference(s): DWR Levee Log, 2002 (HLM 12.95), listed as a 24-inch corrugated metal pipe (CMP). USACE San Joaquin O&M Manual, Unit 601 Part 1 (SJR601.1), 1967, Revised 25 May 2011, (HLM 12.94), listed as a 24-inch CMP].
FS Date: 4/25/2014

View of waterward side.

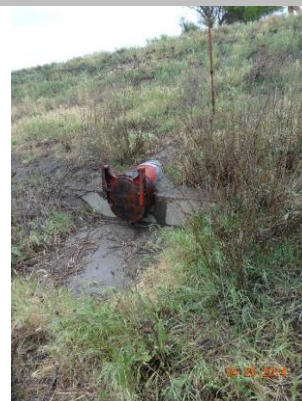
Photo 2 of 3 : UCIP_FA_2020_61874_65411.jpg

Flap gate and concrete headwall visible on waterward side.

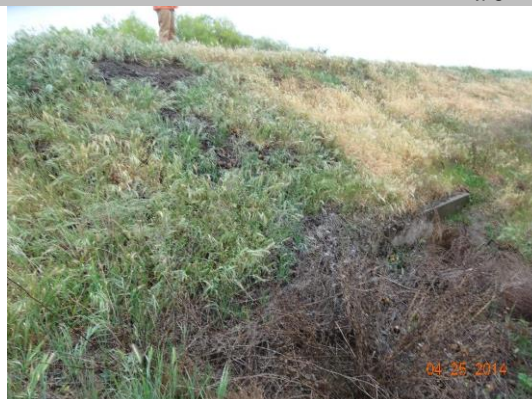
Photo 3 of 3 : UCIP_FA_2020_61874_65410.jpg

View of landward side--concrete headwall visible covered by dense vegetation.

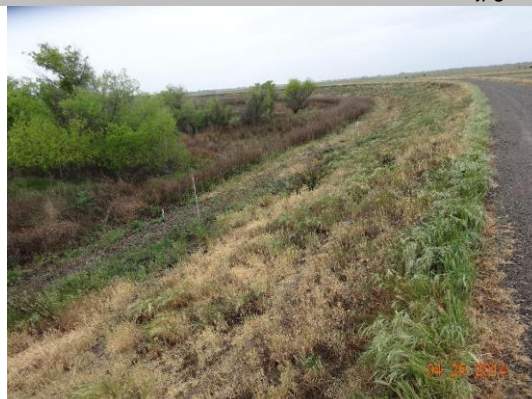
Photo 1 of 3 : UCIP_FA_2020_61875_65389.jpg

DS_ID:19638
 FS_ID:61875
 EP_NO: N/A
 Repair Type: Non-Urgent
 EVAL Issue:
 Crossing Status: Found
 UCIP Comments: 04/25/2014 Dense vegetation limits the inspector's visibility to identify signs of pipe failure (leaks) along the landward slope. Concrete headwall blocked by debris located on landward toe. Recommend clearing debris from landward slope and toe. (O. Magana - DWR UCIP)
 FIELD_STRUCT_DESC: 24-inch corrugated metal gravity drainage pipe through the levee, 14.2 feet below the crown. Flap gate on the waterside (WS) end. Brass cap No. 60 bench mark (BM) on the headwall on the landside (LS). [Additional Reference(s): DWR Levee Log, 2002 (HLM 13.48), listed as a 24-inch corrugated metal pipe (CMP). USACE San Joaquin O&M Manual, Unit 601 Part 1 (SJR601.1), 1967, Revised 25 May 2011, (HLM 13.48), listed as a 24-inch CMP].
 FS Date: 4/25/2014

View of waterward side.

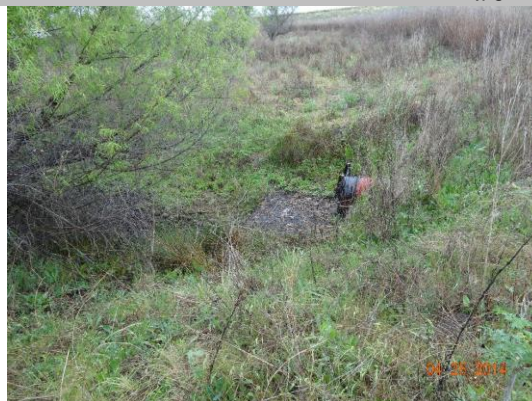
Photo 2 of 3 : UCIP_FA_2020_61875_65387.jpg

View of flap gate and pipe through levee on waterward side.

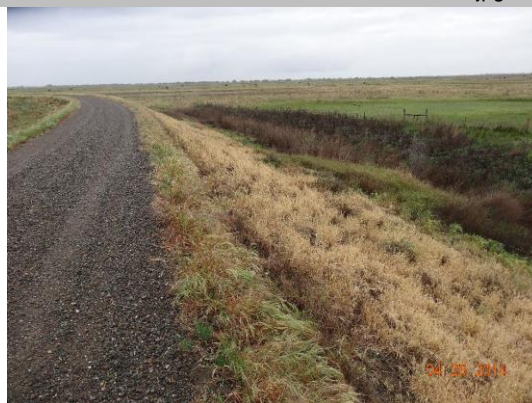
Photo 3 of 3 : UCIP_FA_2020_61875_65388.jpg

View of landward side.

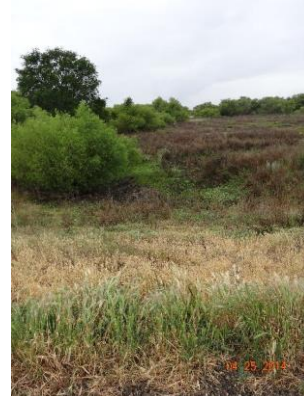
Photo 2 of 3 : UCIP_FA_2020_61876_65417.jpg

Dense vegetation on waterward side.

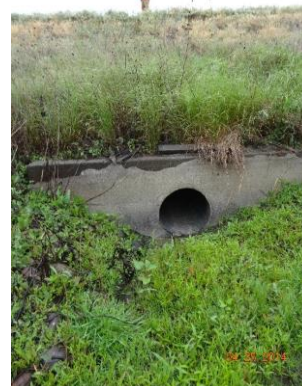
Photo 3 of 3 : UCIP_FA_2020_61876_65416.jpg

Concrete headwall visible from landward side.

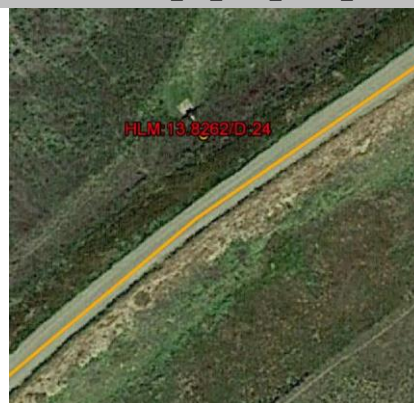
Photo 1 of 1 : UCIP_FA_2020_61877_66286.jpg

DS_ID:19640
 FS_ID:61877
 EP_NO: N/A
 Repair Type: Non-Urgent
 EVAL Issue:
 Crossing Status: Indicator Found
 UCIP Comments: 04/25/2014 No photos available--missed crossing.
 Aerial photograph indicates crossing is present. Need to confirm if crossing is still present on waterward side. (O. Magana - DWR UCIP)
 FIELD_STRUCT_DESC: 24-inch corrugated metal gravity drainage pipe through the levee, 11 feet below the crown. Flap gate on the waterside (WS) end. Brass cap No. 60 bench mark (BM) on the headwall on the landside (LS). [Additional Reference(s): DWR Levee Log, 2002 (HLM 13.83), listed as a 24-inch corrugated metal pipe (CMP). USACE San Joaquin O&M Manual, Unit 601 Part 1 (SJR601.1), 1967, Revised 25 May 2011, (HLM 13.81), listed as a 24-inch CMP].
 FS Date: 4/25/2014

Indicators of crossing visible from aerial photograph.

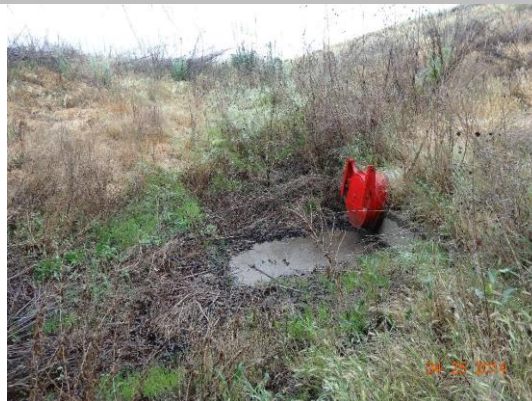
Photo 2 of 3 : UCIP_FA_2020_61878_65452.jpg

View of concrete headwall, concrete apron, and flap gate on waterward side.

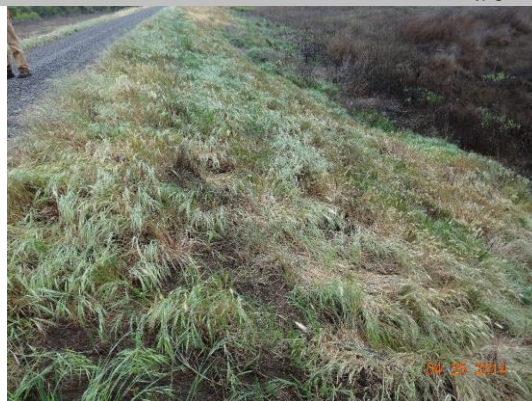
Photo 3 of 3 : UCIP_FA_2020_61878_65448.jpg

View of landward side.

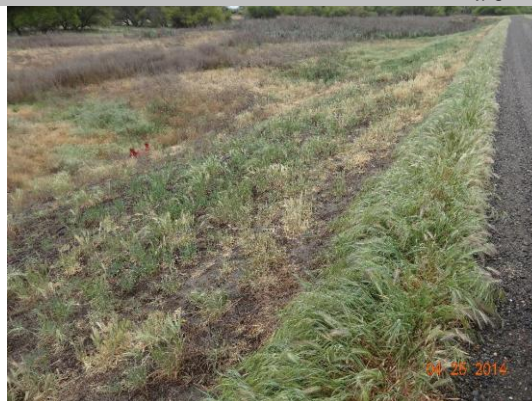
Photo 1 of 3 : UCIP_FA_2020_61879_65455.jpg

DS_ID:19642
 FS_ID:61879
 EP_NO: N/A
 Repair Type: Non-Urgent
 EVAL Issue:
 Crossing Status: Found
 UCIP Comments: 04/25/2014 Dense vegetation limits the inspector's visibility to identify signs of pipe failure (leaks) along the landward slope and toe. Recommend removing vegetation along pipe alignment to conduct proper inspection of structure. (O. Magana - DWR UCIP)
 FIELD_STRUCT_DESC: 24-inch corrugated metal gravity drainage pipe through the levee, 9.7 feet below the crown. Flap gate on the waterside (WS) end. Brass cap No. 60 bench mark (BM) on the headwall on the landside (LS). [Additional Reference(s): DWR Levee Log, 2002 (HLM 14.65), listed as a 24-inch corrugated metal pipe (CMP). USACE San Joaquin O&M Manual, Unit 601 Part 1 (SJR601.1), 1967, Revised 25 May 2011, (HLM 14.65), listed as a 24-inch CMP].
 FS Date: 4/25/2014

View of waterward side.

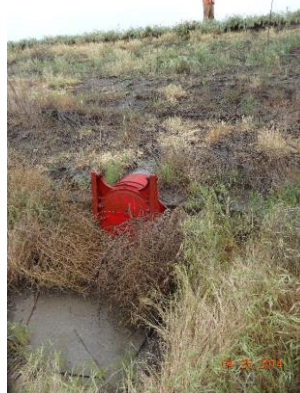
Photo 2 of 3 : UCIP_FA_2020_61879_65454.jpg

Flap gate, concrete headwall, and concrete apron located on waterward toe.

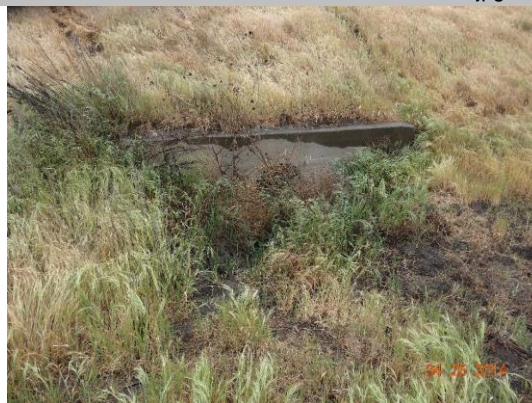
Photo 3 of 3 : UCIP_FA_2020_61879_65453.jpg

Concrete headwall located on landward toe.

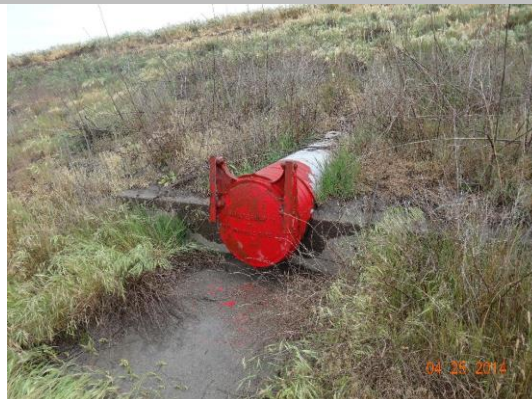
Photo 2 of 3 : UCIP_FA_2020_61880_65457.jpg

Concrete headwall, flap gate, and concrete apron located on waterward side.

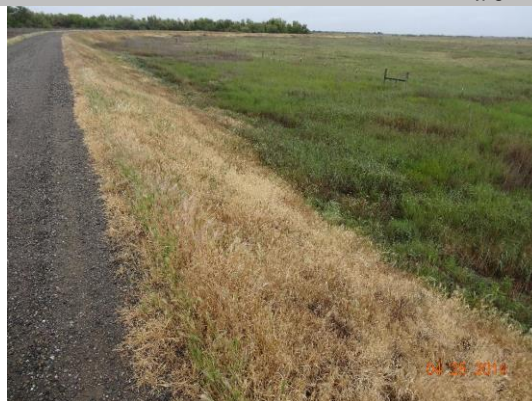
Photo 3 of 3 : UCIP_FA_2020_61880_65458.jpg

View of landward side.
