Flood Control Project Maintenance Levee Inspections

Fall 2020 Levee Maintenance Deficiency Summary Report

San Joaquin River Basin

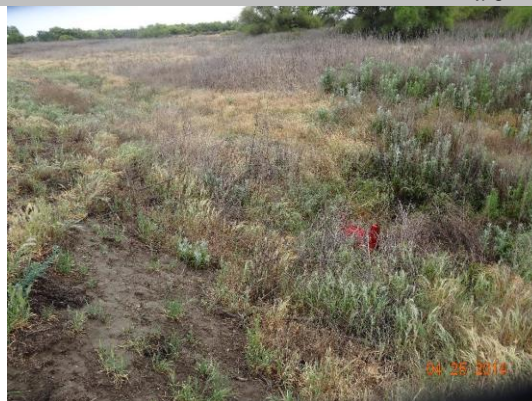
Photo 1 of 3 : UCIP_FA_2020_61881_65464.jpg

DS_ID:19644
 FS_ID:61881
 EP_NO: N/A
 Repair Type: Non-Urgent
 EVAL Issue:
 Crossing Status: Found
 UCIP Comments: 04/25/2014 Dense vegetation limits the inspector's visibility to identify signs of pipe failure (leaks) along the waterward and landward slopes. Recommend removing vegetation along pipe alignment to conduct proper inspection of structure. (O. Magana - DWR UCIP)
 FIELD_STRUCT_DESC: 24-inch corrugated metal gravity drainage pipe through the levee, 8.5 feet below the crown. Flap gate on the waterside (WS) end. Brass cap No. 60 bench mark (BM) on the headwall on the landside (LS). [Additional Reference(s): DWR Levee Log, 2002 (HLM 15.57), listed as a 24-inch corrugated metal pipe (CMP). USACE San Joaquin O&M Manual, Unit 601 Part 1 (SJR601.1), 1967, Revised 25 May 2011, (HLM 15.57), listed as a 24-inch CMP].
 FS Date: 4/25/2014

View of waterward side--flap gate visible through dense vegetation.

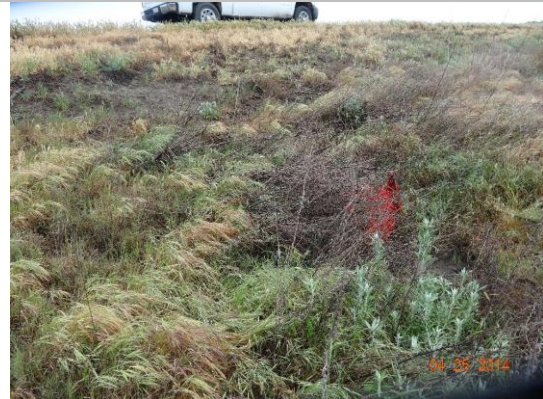
Photo 2 of 3 : UCIP_FA_2020_61881_65463.jpg

View of waterward slope covered by dense vegetation.

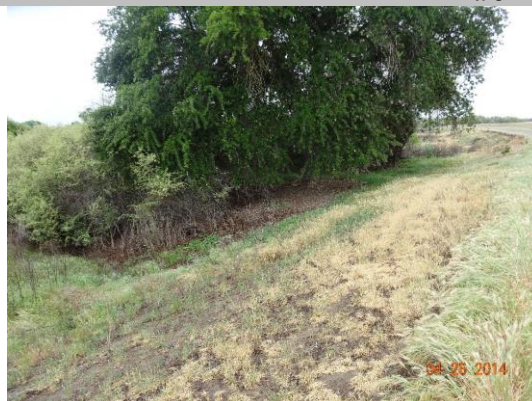
Photo 1 of 3 : UCIP_FA_2020_61882_65471.jpg

DS_ID:19645
FS_ID:61882
EP_NO: N/A
Repair Type: Non-Urgent
EVAL Issue:
Crossing Status: Found
UCIP Comments: 04/25/2014 Dense vegetation limits the inspector's visibility to identify signs of pipe failure (leaks) along the waterward and landward slope. Recommend removing vegetation along pipe alignment to conduct proper inspection of structure. (O. Magana - DWR UCIP)
FIELD_STRUCT_DESC: 24-inch corrugated metal gravity drainage pipe through the levee, 11 feet below the crown. Flap gate on the waterside (WS) end. Brass cap No. 60 bench mark (BM) on the headwall on the landside (LS). [Additional Reference(s): DWR Levee Log, 2002 (HLM 15.82), listed as a 24-inch corrugated metal pipe (CMP). USACE San Joaquin O&M Manual, Unit 601 Part 1 (SJR601.1), 1967, Revised 25 May 2011, (HLM 15.81), listed as a 24-inch CMP].
FS Date: 4/25/2014

View of waterward side.

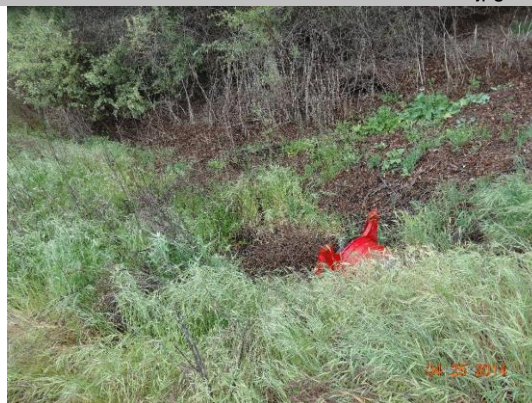
Photo 2 of 3 : UCIP_FA_2020_61882_65470.jpg

Flap gate visible on waterward side.

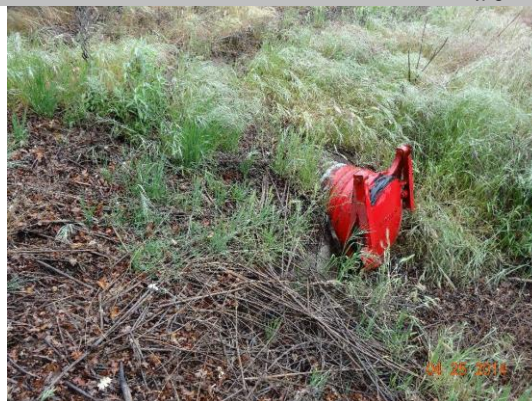
Photo 3 of 3 : UCIP_FA_2020_61882_65469.jpg

Side view of pipe and flap gate on waterward side.

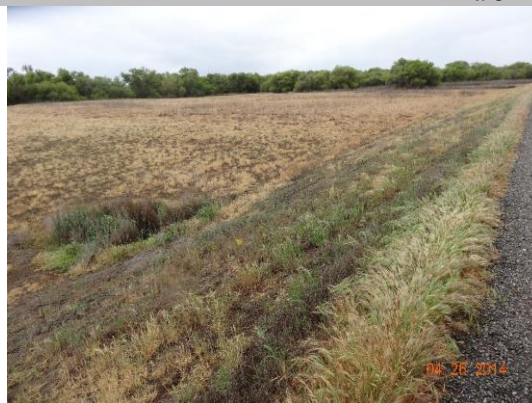
Photo 1 of 3 : UCIP_FA_2020_61883_65476.jpg

DS_ID:19646
 FS_ID:61883
 EP_NO: N/A
 Repair Type: Non-Urgent
 EVAL Issue:
 Crossing Status: Found
 UCIP Comments: 04/25/2014 Dense vegetation limits the inspector's visibility to identify signs of pipe failure (leaks) along the waterward and landward slopes. Recommend removing vegetation along pipe alignment to conduct proper inspection of structure and appurtenances. (O. Magana - DWR UCIP)
 FIELD_STRUCT_DESC: 24-inch corrugated metal gravity drainage pipe through the levee, 11.3 feet below the crown. Flap gate on the waterside (WS) end. Brass cap No. 50 bench mark (BM) on the headwall on the landside (LS). [Additional Reference(s): DWR Levee Log, 2002 (HLM 16.09), listed as a 24-inch corrugated metal pipe (CMP). USACE San Joaquin O&M Manual, Unit 601 Part 1 (SJR601.1), 1967, Revised 25 May 2011, (HLM 16.09), listed as a 24-inch pipe].
 FS Date: 4/25/2014

View of waterward side.

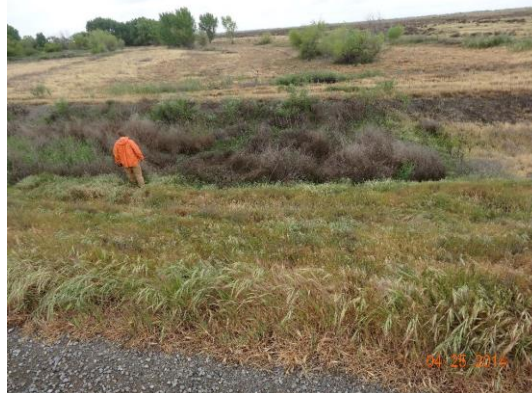
Photo 3 of 3 : UCIP_FA_2020_61884_65478.jpg

DS_ID:19647
FS_ID:61884
EP_NO: N/A
Repair Type: Non-Urgent
EVAL Issue:
Crossing Status: Found
UCIP Comments: 04/25/2014 Dense vegetation limits the inspector's visibility to identify signs of pipe failure (leaks) along the waterward and landward slopes. Recommend removing vegetation along pipe alignment to conduct proper inspection of structure. Unable to find pipe on landward side. (O. Magana - DWR UCIP)
FIELD_STRUCT_DESC: 24-inch corrugated metal gravity drainage pipe through the levee, 14.7 feet below the crown. Flap gate on the waterside (WS) end. Brass cap No. 50 bench mark (BM) on the headwall on the landside (LS). [Additional Reference(s): DWR Levee Log, 2002 (HLM 16.16), listed as a 24-inch corrugated metal pipe (CMP). USACE San Joaquin O&M Manual, Unit 601 Part 1 (SJR601.1), 1967, Revised 25 May 2011, (HLM 16.15), listed as a 24-inch pipe].
FS Date: 4/25/2014

View of landward side.

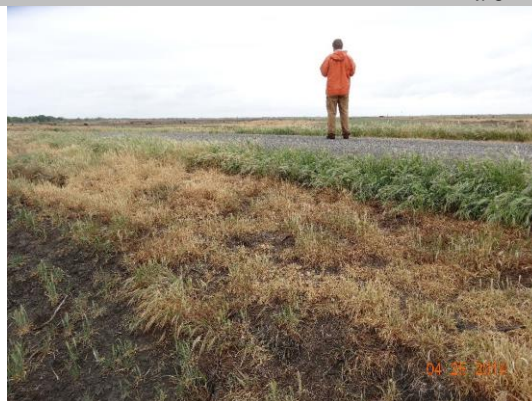
Photo 1 of 3 : UCIP_FA_2020_61886_66288.jpg

DS_ID:19648
 FS_ID:61886
 EP_NO: N/A
 Repair Type: Non-Urgent
 EVAL Issue:
 Crossing Status: Found
 UCIP Comments: 04/25/2014 Dense vegetation limits the inspector's visibility to identify signs of pipe failure (leaks) along the waterward and landward slopes. Recommend removing vegetation along pipe alignment to conduct proper inspection of structure. Unable to find pipe on landward side. (O. Magana - DWR UCIP)
 FIELD_STRUCT_DESC: 24-inch corrugated metal gravity drainage pipe through the levee, 11.4 feet below the crown. Flap gate on the waterside (WS) end. Brass cap No. 50 bench mark (BM) on the headwall on the landside (LS). [Additional Reference(s): DWR Levee Log, 2002 (HLM 16.73), listed as a 24-inch corrugated metal pipe (CMP). USACE San Joaquin O&M Manual, Unit 601 Part 1 (SJR601.1), 1967, Revised 25 May 2011, (HLM 16.72), listed as a 24-inch CMP].
 FS Date: 4/25/2014

View of levee crown at crossing.

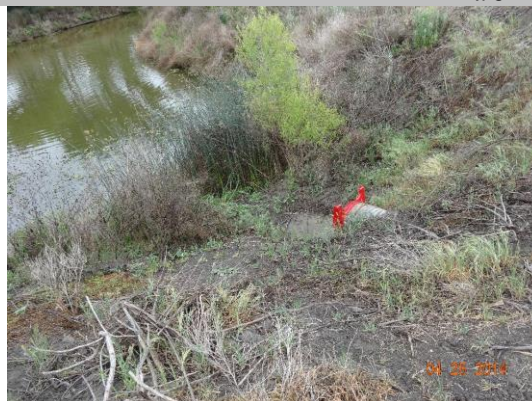
Photo 2 of 3 : UCIP_FA_2020_61886_66289.jpg

View of waterward side.

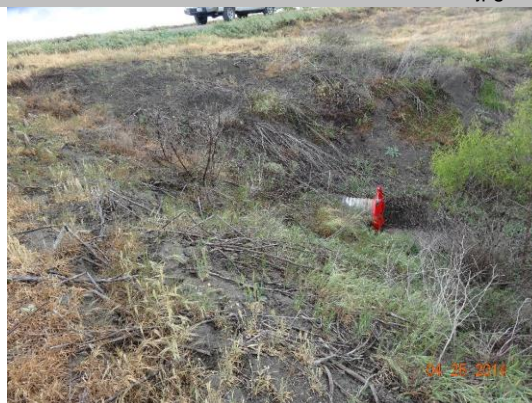
Photo 3 of 3 : UCIP_FA_2020_61886_66287.jpg

View of flap gate visible on waterward side.

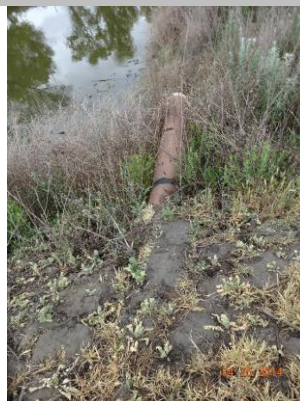
Photo 1 of 2 : UCIP_FA_2020_61888_71487.jpg

View of pipe located on waterward side.

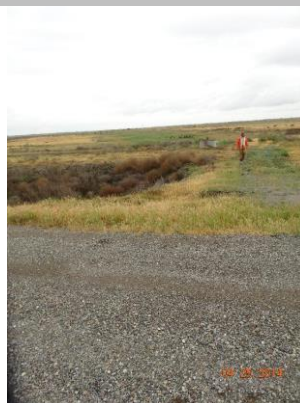
Photo 2 of 2 : UCIP_FA_2020_61888_71486.jpg

View of landward side.

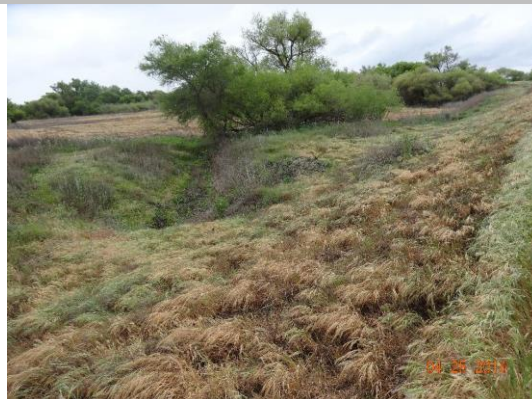
Photo 1 of 3 : UCIP_FA_2020_61889_65518.jpg

DS_ID:19577
FS_ID:61889
EP_NO: N/A
Repair Type: Non-Urgent
EVAL Issue:
Crossing Status: Found
UCIP Comments: 04/25/2014 Dense vegetation limits the inspector's visibility to identify signs of pipe failure (leaks) along the waterward and landward slopes. Concrete headwall is buried by dense vegetation. Recommend removing vegetation along pipe alignment to conduct proper inspection of structure. (O. Magana - DWR UCIP)
FIELD_STRUCT_DESC: 24-inch corrugated metal gravity drainage pipe through the levee, 11.5 feet below the crown. Flap gate on the waterside (WS) end. Brass cap No. 50 bench mark (BM) on the headwall on the landside (LS). [Additional Reference(s): DWR Levee Log, 2002 (HLM 17.01), listed as a 24-inch corrugated metal pipe (CMP). USACE San Joaquin O&M Manual, Unit 601 Part 1 (SJR601.1), 1967, Revised 25 May 2011, (HLM 17.01), listed as a 24-inch CMP].
FS Date: 4/25/2014

View of waterward side.

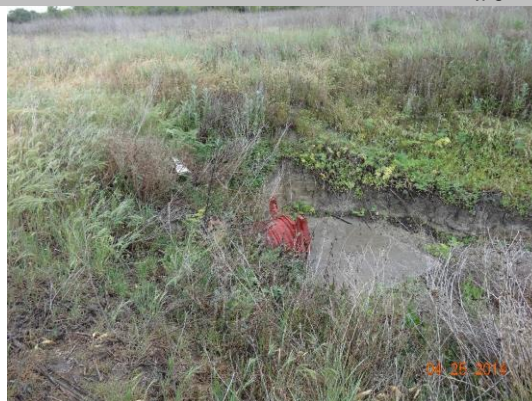
Photo 2 of 3 : UCIP_FA_2020_61889_65519.jpg

Flap gate visible on waterward side.

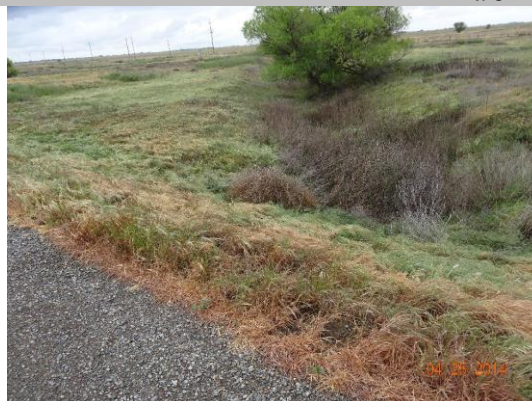
Photo 3 of 3 : UCIP_FA_2020_61889_65517.jpg

View of landward side.

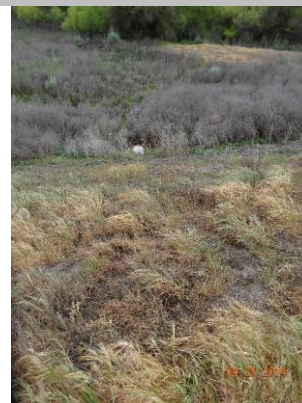
Photo 1 of 3 : UCIP_FA_2020_61890_65525.jpg

DS_ID:19578
 FS_ID:61890
 EP_NO: N/A
 Repair Type: Non-Urgent
 EVAL Issue:
 Crossing Status: Found
 UCIP Comments: 04/25/2014 Dense vegetation limits the inspector's visibility to identify signs of pipe failure (leaks) along the waterward and landward slopes. Recommend removing vegetation along pipe alignment to conduct proper inspection of structure. Sediment buildup inside pipe visible from landward side. Recommend clearing pipe. (O. Magana - DWR UCIP)
 FIELD_STRUCT_DESC: 24-inch corrugated metal gravity drainage pipe through the levee, 11.5 feet below the crown. Flap gate on the waterside (WS) end. Brass cap No. 50 bench mark (BM) on the headwall on the landside (LS). [Additional Reference(s): DWR Levee Log, 2002 (HLM 17.20), listed as a 24-inch corrugated metal pipe (CMP). USACE San Joaquin O&M Manual, Unit 601 Part 1 (SJR601.1), 1967, Revised 25 May 2011, (HLM 17.19), listed as a 24-inch CMP].

View of waterward side.

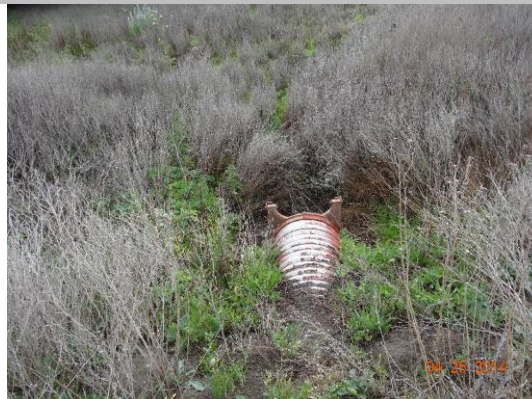
Photo 2 of 3 : UCIP_FA_2020_61890_65521.jpg

Pipe visible on waterward side.

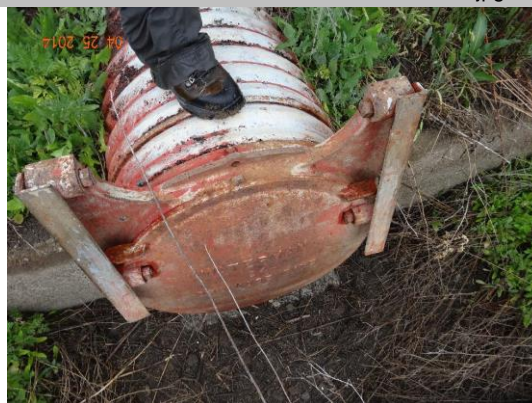
Photo 3 of 3 : UCIP_FA_2020_61890_65520.jpg

Flap gate visible on waterward toe.

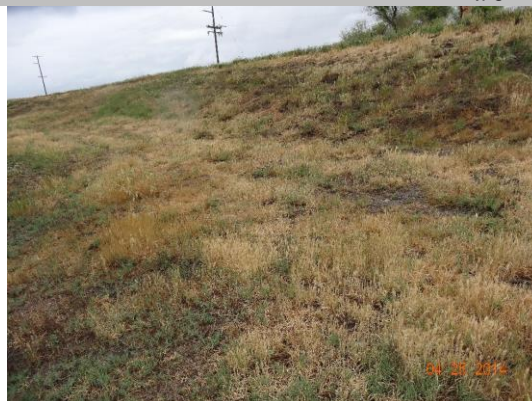
Photo 1 of 3 : UCIP_FA_2020_61891_65551.jpg

DS_ID:19579
FS_ID:61891
EP_NO: N/A
Repair Type: Non-Urgent
EVAL Issue:
Crossing Status: Found
UCIP Comments: 04/25/2014 Dense vegetation limits the inspector's visibility to identify signs of pipe failure (leaks) along the waterward and landward slope. Recommend removing vegetation along pipe alignment to conduct proper inspection of structure. (O. Magana - DWR UCIP)
FIELD_STRUCT_DESC: 24-inch corrugated metal gravity drainage pipe through the levee, 15.8 feet below the crown. Flap gate on the waterside (WS) end. Brass cap No. 50 bench mark (BM) on the headwall on the landside (LS). [Additional Reference(s): DWR Levee Log, 2002 (HLM 17.27), listed as a 24-inch corrugated metal pipe (CMP). USACE San Joaquin O&M Manual, Unit 601 Part 1 (SJR601.1), 1967, Revised 25 May 2011, (HLM 17.26), listed as a 24-inch CMP].
FS Date: 4/25/2014

View of waterward slope.

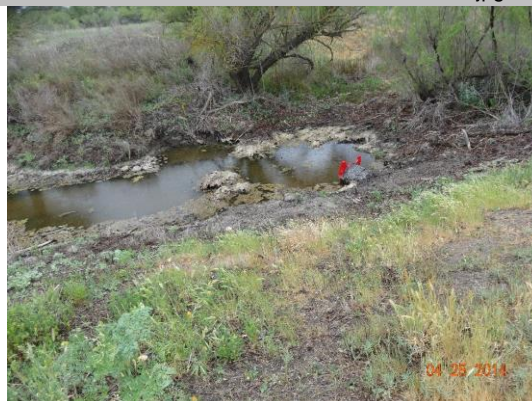
Photo 2 of 3 : UCIP_FA_2020_61891_65552.jpg

Pipe visible on waterward side.

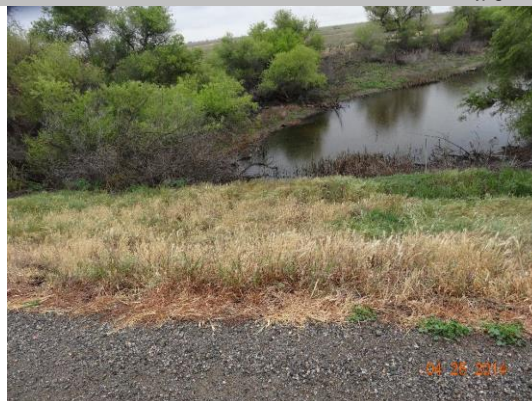
Photo 3 of 3 : UCIP_FA_2020_61891_65554.jpg

View of landward side.

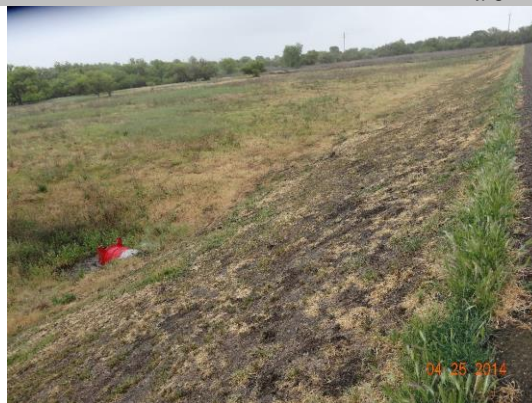
Photo 1 of 3 : UCIP_FA_2020_61892_65547.jpg

DS_ID:19580
 FS_ID:61892
 EP_NO: N/A
 Repair Type: Non-Urgent
 EVAL Issue:
 Crossing Status: Found
 UCIP Comments: 04/25/2014 Dense vegetation limits the inspector's visibility to identify signs of pipe failure (leaks) along the landward slope. Recommend removing vegetation along pipe alignment to conduct proper inspection of structure. (O. Magana - DWR UCIP)
 FIELD_STRUCT_DESC: 24-inch corrugated metal gravity drainage pipe through the levee, 9.5 feet below the crown. Flap gate on the waterside (WS) end. Brass cap No. 50 bench mark (BM) on the headwall on the landside (LS). [Additional Reference(s): DWR Levee Log, 2002 (HLM 17.53), listed as a 24-inch corrugated metal pipe (CMP). USACE San Joaquin O&M Manual, Unit 601 Part 1 (SJR601.1), 1967, Revised 25 May 2011, (HLM 17.53), listed as a 24-inch CMP].
 FS Date: 4/25/2014

View of waterward side.

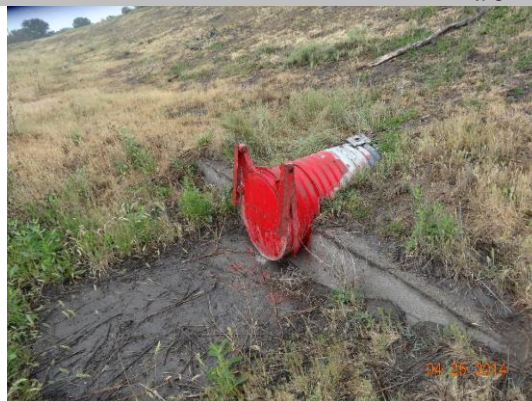
Photo 2 of 3 : UCIP_FA_2020_61892_65546.jpg

Flap gate visible on waterward side.

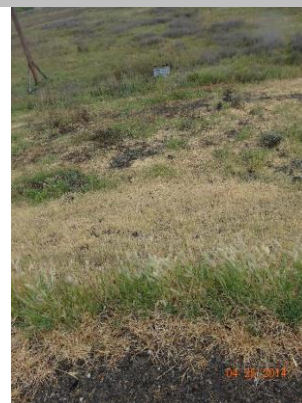
Photo 3 of 3 : UCIP_FA_2020_61892_65545.jpg

View of landward side--riser at levee toe.

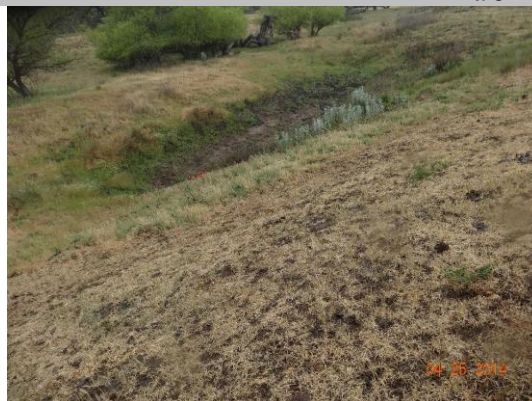
Photo 1 of 3 : UCIP_FA_2020_61893_65557.jpg

| DS_ID:19581 FS_ID:61893 EP_NO: N/A Repair Type: Non-Urgent EVAL Issue: Crossing Status: Found UCIP Comments: 04/25/2014 Need to contact owner. Recommend investigating integrity of pipe wall through levee heavy corrosion visible from landward side. (O. Magana - DWR UCIP) FIELD_STRUCT_DESC: 24-inch corrugated metal gravity drainage pipe through the levee, 11.5 feet below the crown. Flap gate on the waterside (WS) end. Brass cap No. 50 bench mark (BM) on the headwall on the landside (LS). [Additional Reference(s): DWR Levee Log, 2002 (HLM 18.21), listed as a 24-inch corrugated metal pipe (CMP). USACE San Joaquin O&M Manual, Unit 601 Part 1 (SJR601.1), 1967, Revised 25 May 2011, (HLM 18.19), listed as a 24-inch CMP]. FS Date: 4/25/2014 | | | | | | |

View of waterward side.

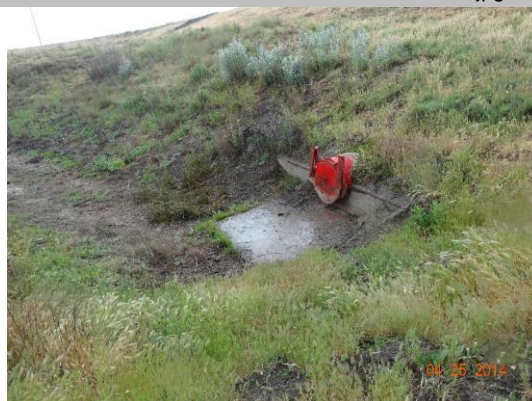
Photo 2 of 3 : UCIP_FA_2020_61893_65556.jpg

Flap gate visible on waterward side.

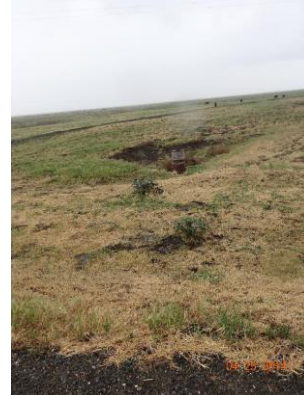
Photo 3 of 3 : UCIP_FA_2020_61893_65555.jpg

View of landward side.

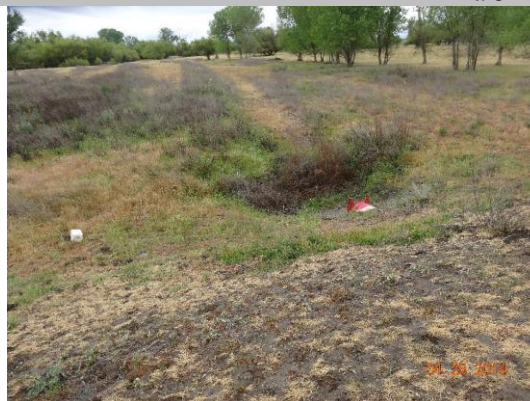
Photo 1 of 3 : UCIP_FA_2020_61894_65563.jpg

DS_ID:19582
 FS_ID:61894
 EP_NO: N/A
 Repair Type: No Action Needed
 EVAL Issue:
 Crossing Status: Found
 UCIP Comments:
 FIELD_STRUCT_DESC: 24-inch corrugated metal gravity drainage pipe through the levee, 9.4 feet below the crown. Flap gate on the waterside (WS) end. Brass cap No. 50 bench mark (BM) on the headwall on the landside (LS). [Additional Reference(s): DWR Levee Log, 2002 (HLM 18.47), listed as a 24-inch corrugated metal pipe (CMP). USACE San Joaquin O&M Manual, Unit 601 Part 1 (SJR601.1), 1967, Revised 25 May 2011, (HLM 18.45), listed as a 24-inch CMP].
 FS Date: 4/25/2014

View of waterward side.

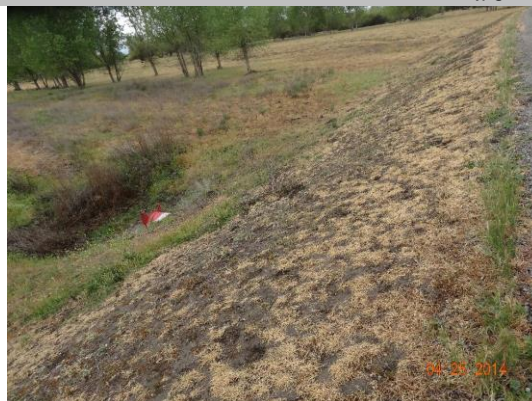
Photo 2 of 3 : UCIP_FA_2020_61894_65562.jpg

View of waterward slope.

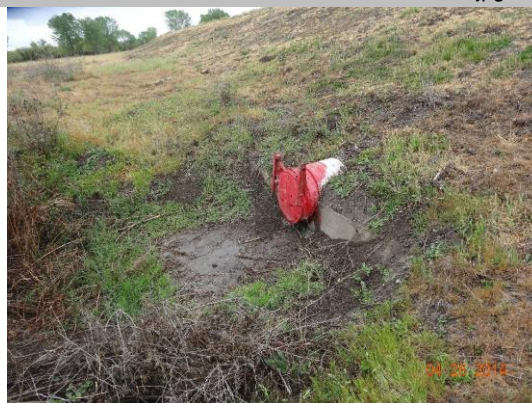
Photo 3 of 3 : UCIP_FA_2020_61894_65561.jpg

Flap gate visible on waterward side.

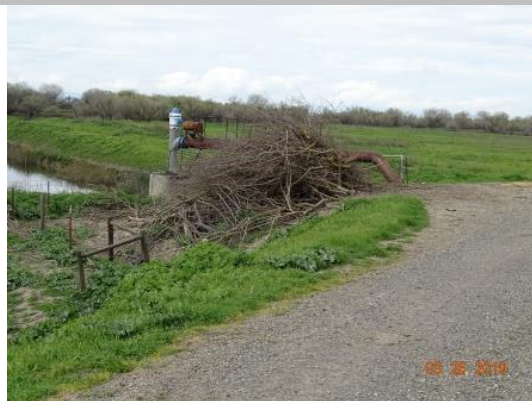
Photo 1 of 1 : FA_2020_NA0010_118_134_20200901_00020.jpg

View of prunings on waterside slope. (Spring 2019)

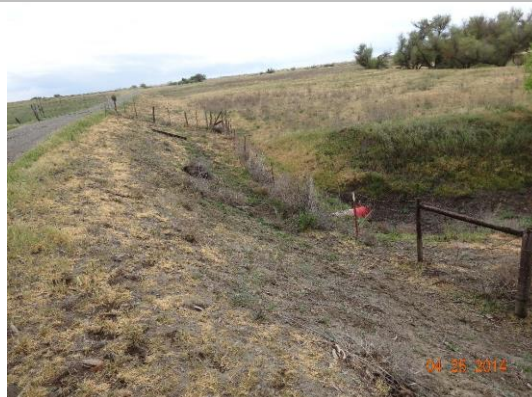
Photo 2 of 3 : UCIP_FA_2020_61896_65623.jpg

DS_ID:19593
 FS_ID:61896
 EP_NO: N/A
 Repair Type: Non-Urgent
 EVAL Issue:
 Crossing Status: Found
 UCIP Comments: 04/25/2014 Dense vegetation limits the inspector's visibility to identify signs of pipe failure (leaks) along the landward slope. Recommend removing vegetation along pipe alignment to conduct proper inspection of structure. (O. Magana - DWR UCIP)
 FIELD_STRUCT_DESC: 24-inch corrugated metal gravity drainage pipe through the levee, 12 feet below the crown. Flap gate on the waterside (WS) end. Brass cap No. 50 bench mark (BM) on the headwall on the landside (LS). [Additional Reference(s): DWR Levee Log, 2002 (HLM 18.80), listed as a 24-inch corrugated metal pipe (CMP). USACE San Joaquin O&M Manual, Unit 601 Part 1 (SJR601.1), 1967, Revised 25 May 2011, (HLM 18.79), listed as a 24-inch CMP].
 FS Date: 4/25/2014

View of waterward side.

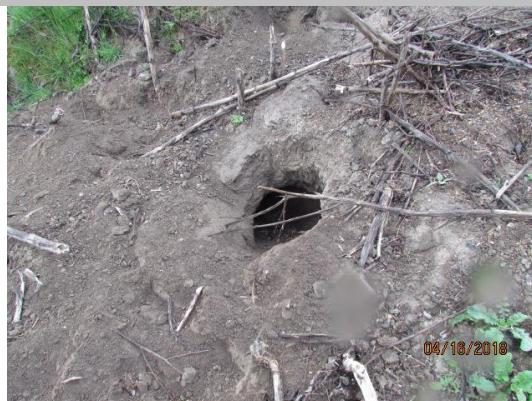
Photo 1 of 1 : FA_2020_NA0010_118_94_20200901_00006.jpg

| Several large rodent holes on landward slope. | | | | | |

Looking at large rodent hole on landward slope. (Spring 2018)

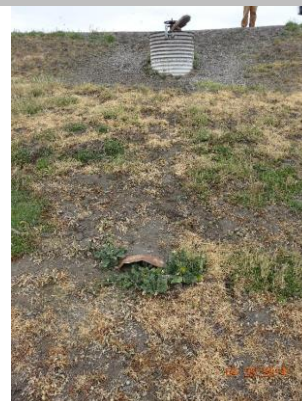
Photo 1 of 3 : UCIP_FA_2020_61897_65631.jpg

DS_ID:19594
FS_ID:61897
EP_NO: N/A
Repair Type: Non-Urgent
EVAL Issue:
Crossing Status: Found
UCIP Comments: 04/25/2014 Non-functional crossing--pipe is buried on waterward side. Sediment buildup in pipe visible from landward side. Need to coordinate with owner to determine status. If crossing is no longer in use, owner will need to coordinate with DWR Inspector and CVFPB to properly abandon. (O. Magana - DWR UCIP)
FIELD_STRUCT_DESC: 24-inch corrugated metal gravity drainage pipe through the levee, 13 feet below the crown. Flap gate on the waterside (WS) end. Brass cap No. 40 bench mark (BM) on the headwall on the landside (LS). [Additional Reference(s): DWR Levee Log, 2002 (HLM 19.18), listed as a 24-inch corrugated metal pipe (CMP). USACE San Joaquin O&M Manual, Unit 601 Part 1 (SJR601.1), 1967, Revised 25 May 2011, (HLM 19.17), listed as a 24-inch CMP].
FS Date: 4/25/2014

View of waterward slope. CMP riser and pipe visible.

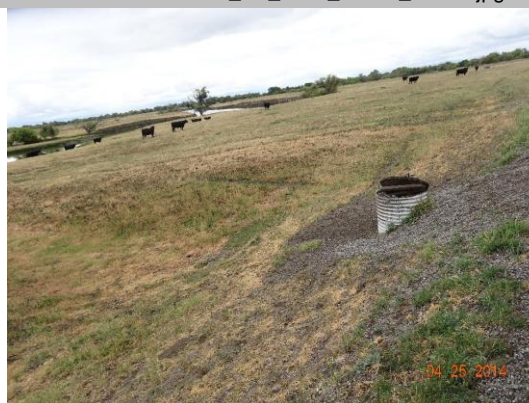
Photo 2 of 3 : UCIP_FA_2020_61897_65630.jpg

View of waterward side.

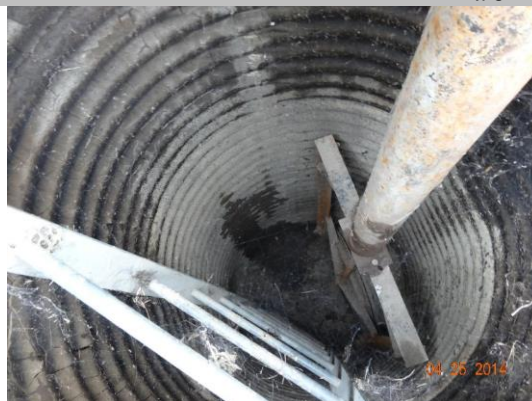
Photo 3 of 3 : UCIP_FA_2020_61897_65632.jpg

Inside view of CMP riser.

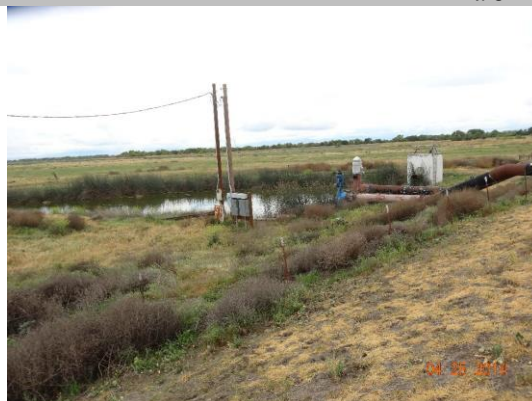
Photo 1 of 3 : UCIP_FA_2020_61898_71421.jpg

DS_ID:24871
 FS_ID:61898
 EP_NO: N/A
 Repair Type: Non-Urgent
 EVAL Issue:
 Crossing Status: Found
 UCIP Comments: 04/25/2014 New crossing found during field inspection--Need to contact owner to obtain additional information about crossing. (O. Magana - DWR UCIP)
 FIELD_STRUCT_DESC: 1 of 2: 20-inch steel drainage discharge pipe through the levee, at an unknown depth. Pump station and electrical panel on the landside (LS). This pipe was field discovered.
 FS Date: 4/25/2014

View of landward side.

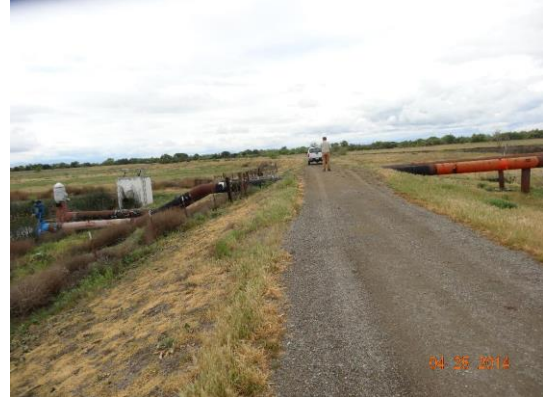
Photo 2 of 3 : UCIP_FA_2020_61898_71420.jpg

Overview of levee crown at crossing.

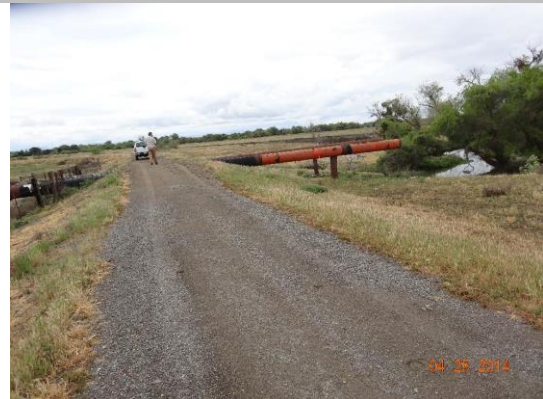
Photo 3 of 3 : UCIP_FA_2020_61898_71423.jpg

View of waterward slope.

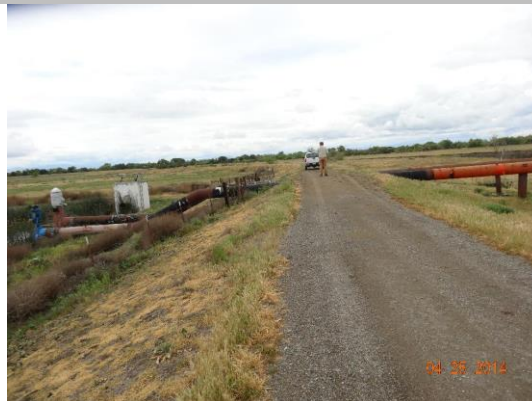
Photo 2 of 3 : UCIP_FA_2020_61899_71425.jpg

| DS_ID:24872 FS_ID:61899 EP_NO: N/A Repair Type: Non-Urgent EVAL Issue: Crossing Status: Found UCIP Comments: 04/25/2014 New crossing found during field inspection--Need to contact owner to obtain additional information about crossing. (O. Magana - DWR UCIP) FIELD_STRUCT_DESC: 2 of 2: 20-inch steel drainage discharge pipe through the levee, at an unknown depth. Pump station and electrical panel on the landside (LS). This pipe was field discovered. FS Date: 4/25/2014 | | | | | | |

View of levee crown at crossings.

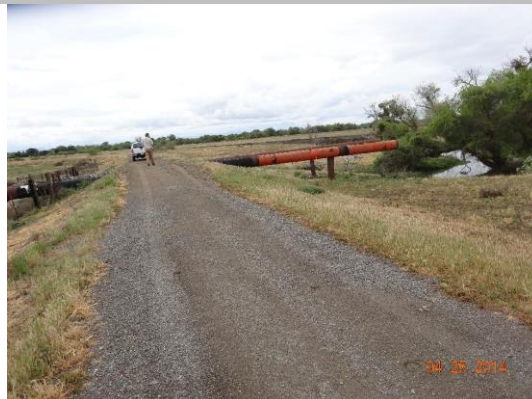
Photo 3 of 3 : UCIP_FA_2020_61899_71424.jpg

View of waterward slope.

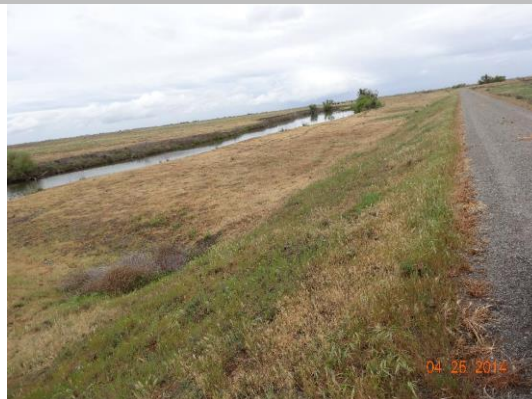
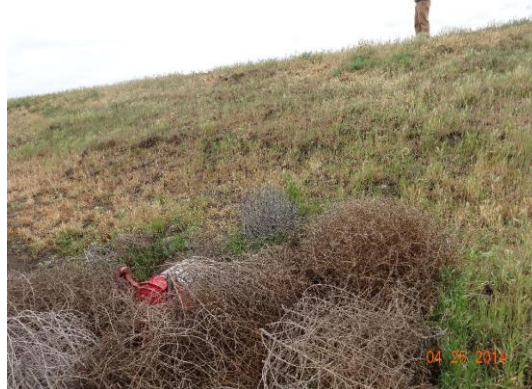
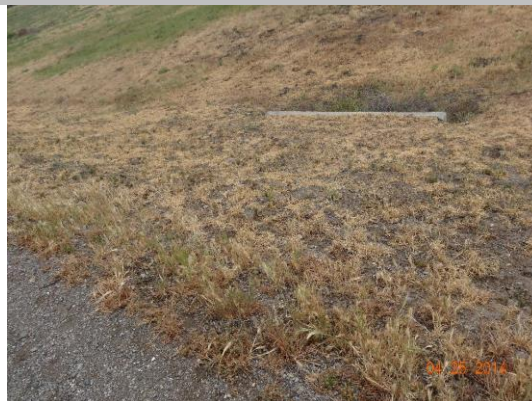
DS_ID:19596
 FS_ID:61901
 EP_NO: N/A
 Repair Type: Non-Urgent
 EVAL Issue:
 Crossing Status: Found
 UCIP Comments: 04/25/2014 Dense vegetation limits the inspector's visibility to identify signs of pipe failure (leaks) along the waterward slope. Recommend removing vegetation along pipe alignment to conduct proper inspection of structure. Dense vegetation blocks both waterward and landward headwalls. Sediment buildup in pipe visible from landward side. (O. Magana - DWR UCIP)
 FIELD_STRUCT_DESC: 24-inch corrugated metal gravity drainage pipe through the levee, 8 feet below the crown. Flap gate on the waterside (WS) end. Brass cap No. 40 bench mark (BM) on the headwall on the landside (LS). [Additional Reference(s): DWR Levee Log, 2002 (HLM 19.54), listed as a 24-inch corrugated metal pipe (CMP). USACE San Joaquin O&M Manual, Unit 601 Part 1 (SJR601.1), 1967, Revised 25 May 2011, (HLM 19.54), listed as a 24-inch CMP].

View of waterward side.

Flap gate visible on waterward side--potential erosion present on slope.

View of landward slope.

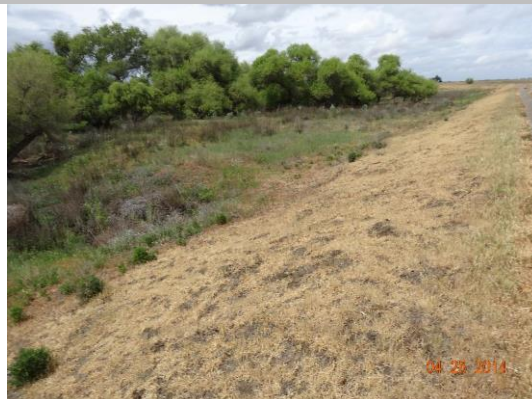
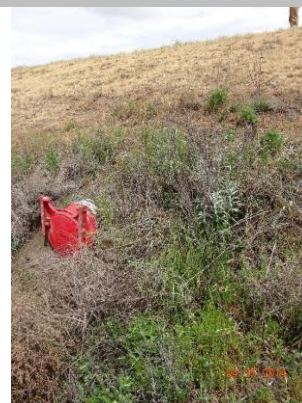
Flap gate visible on WS toe.

DS_ID:19598
FS_ID:61903
EP_NO: N/A
Repair Type: Non-Urgent
EVAL Issue:
Crossing Status: Found
UCIP Comments: 04/25/2014 Recommend removing vegetation and sediment buildup from both waterward and landward concrete headwalls. (O. Magana - DWR UCIP)
FIELD_STRUCT_DESC: 24-inch corrugated metal gravity drainage pipe through the levee, 8.5 feet below the crown. Flap gate on the waterside (WS) end. Brass cap No. 40 bench mark (BM) on the headwall on the landside (LS). [Additional Reference(s): DWR Levee Log, 2002 (HLM 20.19), listed as a 24-inch corrugated metal pipe (CMP). USACE San Joaquin O&M Manual, Unit 601 Part 1 (SJR601.1), 1967, Revised 25 May 2011, (HLM 20.18), listed as a 24-inch CMP].
FS Date: 4/25/2014

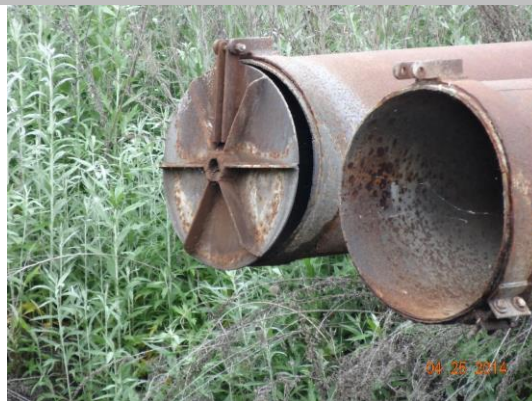
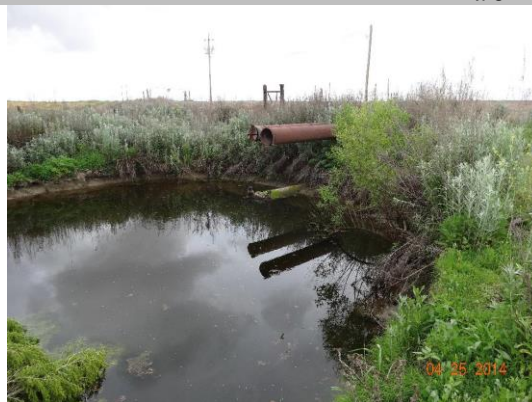
| DS_ID:24873 FS_ID:39285 EP_NO: N/A Repair Type: Non-Urgent EVAL Issue: Crossing Status: Found UCIP Comments: 04/25/2014 Dense vegetation limits the inspector's visibility to identify signs of pipe failure (leaks) along the waterward slope. Recommend removing vegetation along pipe alignment to conduct proper inspection of structure. (DWR UCIP - O. Magana) FIELD_STRUCT_DESC: 12-inch steel drainage discharge pipe sleeved through a 24-inch steel pipe through levee, at an unknown depth. FS Date: 4/25/2014 | | | | | |

Outlet visible on waterward side.

View of waterward side.

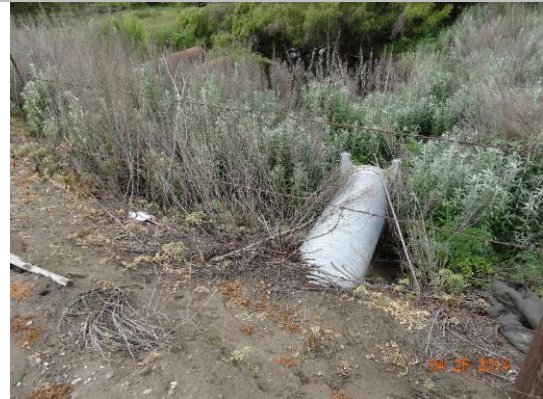
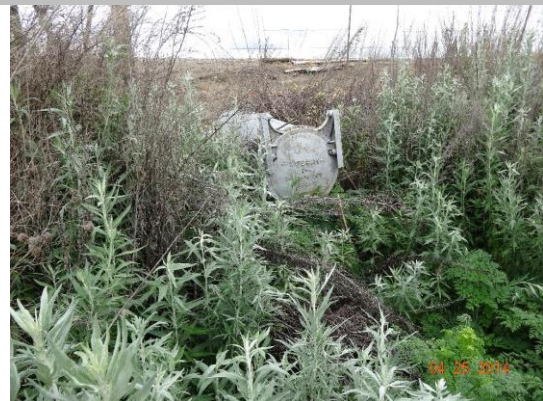
View of WS.

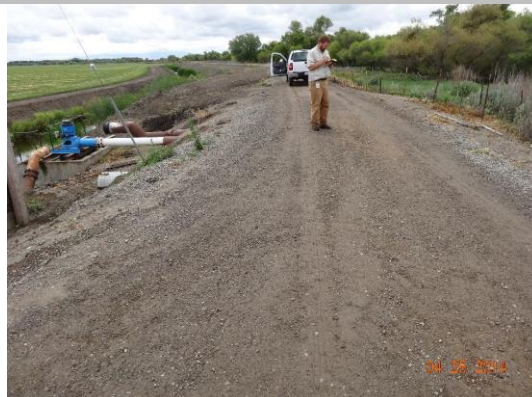
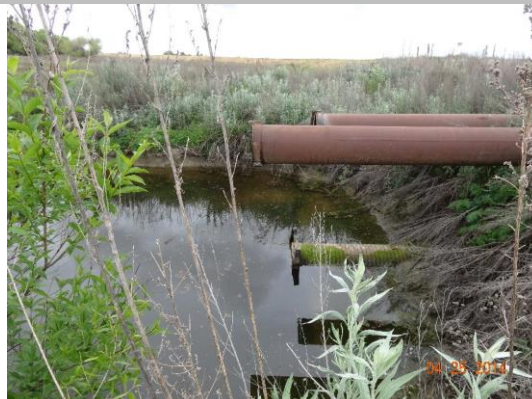
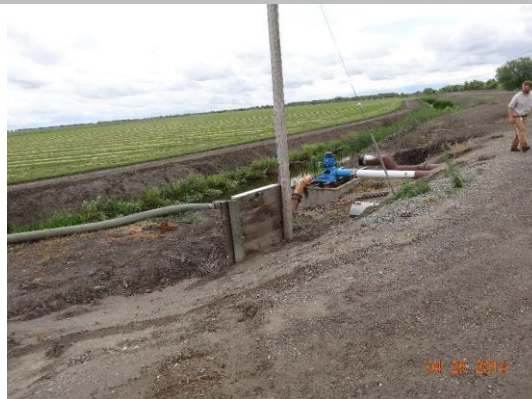
DS_ID:19600
FS_ID:61905
EP_NO: N/A
Repair Type: Non-Urgent
EVAL Issue:
Crossing Status: Found
UCIP Comments: 04/25/2014 Crossing partially submersed--no signs of failure of pipe present along pipe alignment. Recommend contacting owner to determine status of crossing and condition. (O. Magana - DWR UCIP)
FIELD_STRUCT_DESC: 36-inch corrugated metal gravity drainage pipe through the levee, 10.5 feet below the crown. Flap gate on the waterside (WS) end. Brass cap No. 40 bench mark (BM) on the headwall on the landside (LS). [Additional Reference(s): DWR Levee Log, 2002 (HLM 20.28), listed as a 36-inch corrugated metal pipe (CMP). USACE San Joaquin O&M Manual, Unit 601 Part 1 (SJR601.1), 1967, Revised 25 May 2011, (HLM 20.27), listed as a 36-inch CMP].
FS Date: 4/25/2014

Overview of levee crown at crossing--multiple crossings at this location.

Multiple crossings visible on waterward side--36 inch CMP is submersed in water.

View of landward side.

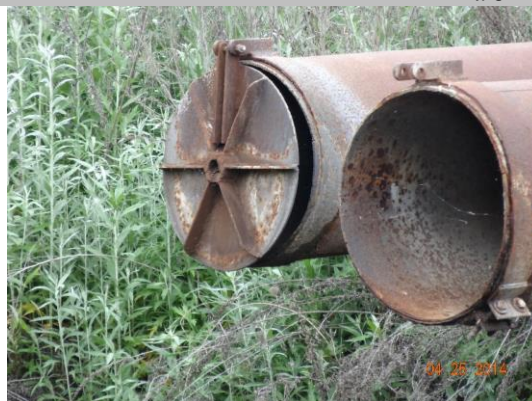
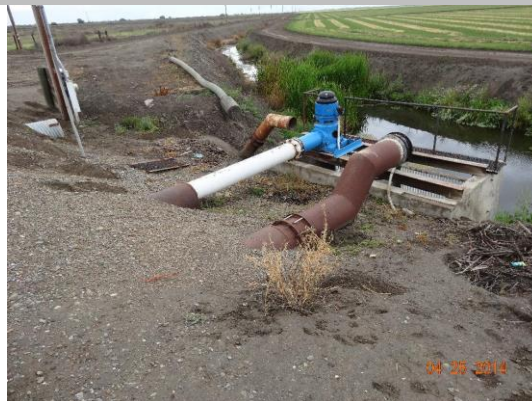
DS_ID:24874
 FS_ID:61906
 EP_NO: N/A
 Repair Type: Non-Urgent
 EVAL Issue:
 Crossing Status: Found
 UCIP Comments: 04/25/2014 Dense vegetation limits the inspector's visibility to identify signs of pipe failure (leaks) along the waterward slope. Recommend removing vegetation along pipe alignment to conduct proper inspection of structure. (O. Magana - DWR UCIP)
 FIELD_STRUCT_DESC: 18-inch steel drainage discharge pipe sleeved through a 24-inch steel pipe through levee, at an unknown depth.
 FS Date: 4/25/2014

Outlets visible on waterward side.

View of waterward side.

View of landward side.

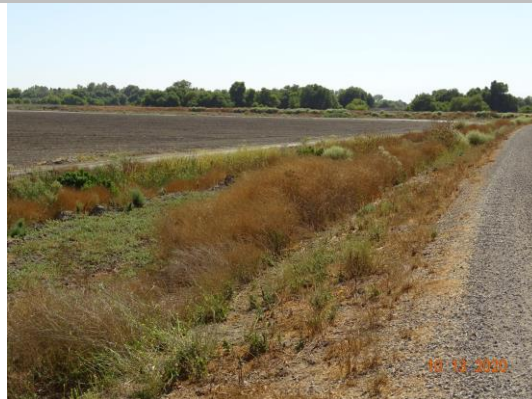
Photo 1 of 1 : FA_2020_NA0010_118_109_20201020_00276.jpg

Vegetation on the landside slope and toe. (Fall 2020)

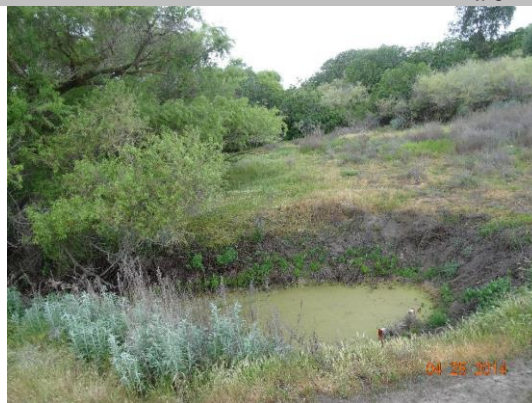
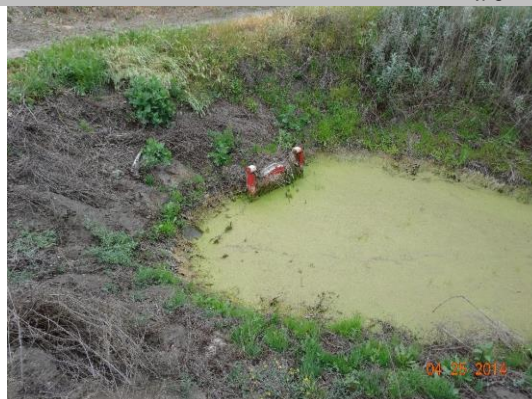
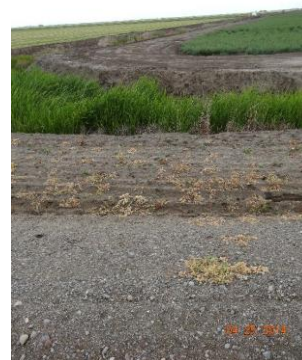
| DS_ID:19603 FS_ID:61910 EP_NO: N/A Repair Type: Non-Urgent EVAL Issue: Crossing Status: Found UCIP Comments: 04/25/2014 Crossing is non-functional--crossing buried on landward side. Need to contact owner to determine status of crossing. If crossing is no longer used need to coordinate with CVFPB for proper abandonment. (O. Magana - DWR UCIP) FIELD_STRUCT_DESC: 36-inch corrugated metal gravity drainage pipe through the levee, 11.5 feet below the crown. Flap gate on the waterside (WS) end. Brass cap No. 40 bench mark (BM) on the headwall on the landside (LS). [Additional Reference(s): DWR Levee Log, 2002 (HLM 21.41), listed as a 36-inch corrugated metal pipe (CMP). USACE San Joaquin O&M Manual, Unit 601 Part 1 (SJR601.1), 1967, Revised 25 May 2011, (HLM 21.40), listed as a 36-inch CMP]. FS Date: 4/25/2014 | | | | | | |

View of waterward side.

Flap gate half way submersed located on waterward side.

View of landward side.

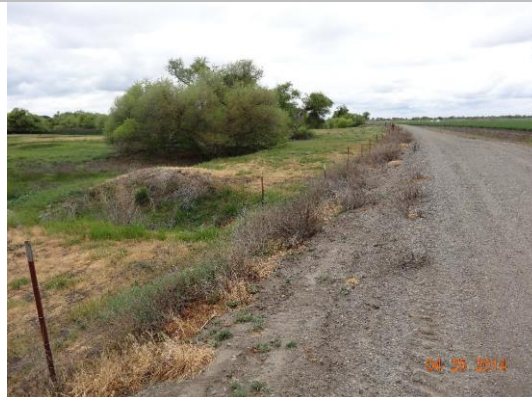
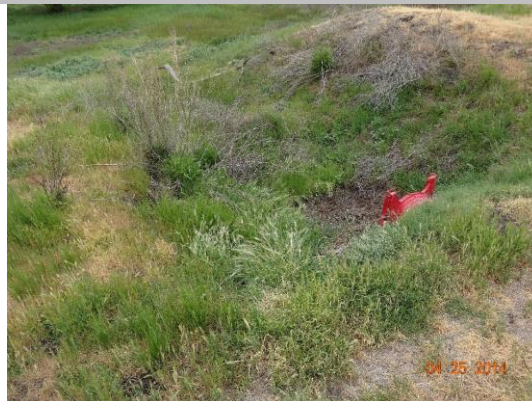
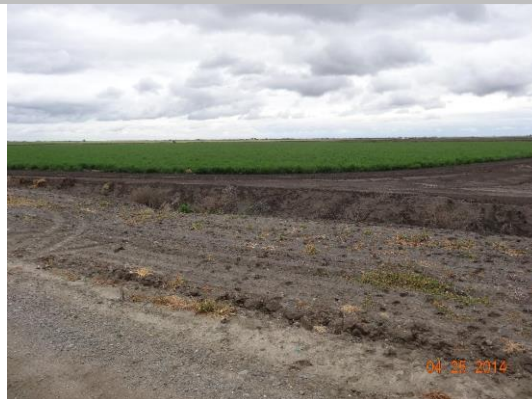
| DS_ID:19604 FS_ID:61911 EP_NO: N/A Repair Type: Non-Urgent EVAL Issue: Crossing Status: Found UCIP Comments: 04/25/2014 Non-functional crossing-landward side is buried. Need to contact owner to determine status of crossing. If crossing is no longer used need to coordinate with CVFPB for proper abandonment. (O. Magana - DWR UCIP) FIELD_STRUCT_DESC: 24-inch corrugated metal gravity drainage pipe through the levee, 9 feet below the crown. Flap gate on the waterside (WS) end. Brass cap No. 40 bench mark (BM) on the headwall on the landside (LS). [Additional Reference(s): DWR Levee Log, 2002 (HLM 21.78), listed as a 24-inch corrugated metal pipe (CMP). USACE San Joaquin O&M Manual, Unit 601 Part 1 (SJR601.1), 1967, Revised 25 May 2011, (HLM 21.76), listed as a 24-inch CMP]. FS Date: 4/25/2014 | | | | | | |

View of waterward side.

Flap gate visible on waterward side.

View of landward side.

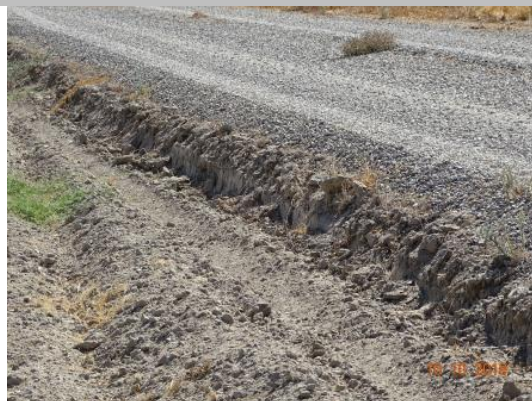
Photo 1 of 1 : FA_2020_NA0010_118_130_20200901_00019.jpg

| Tilling along landside toe partially cut into the slope. | | | | | |

View of tilling from toe looking towards the levee. (Fall 2018)

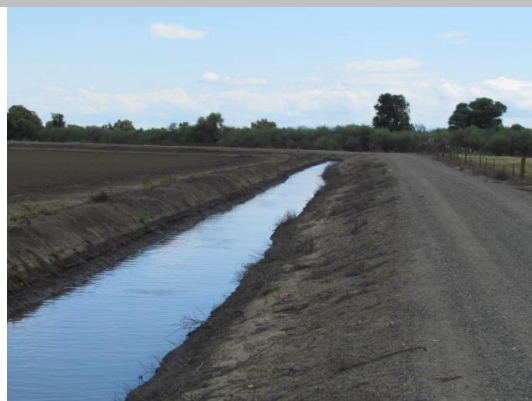
Photo 1 of 1 : FA_2020_NA0010_118_22_20200901_00005.jpg

| Ditch has encroached into landside toe and slope. | | | | | |

Looking upstream at irrigation at landside toe.

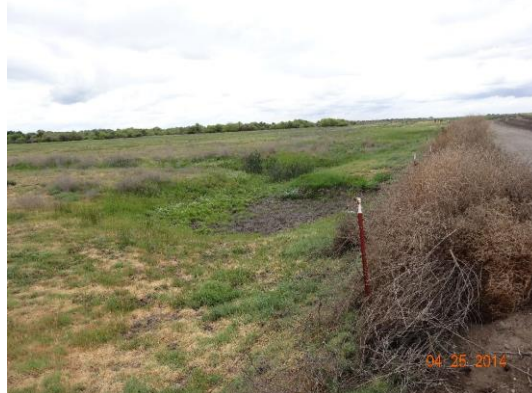
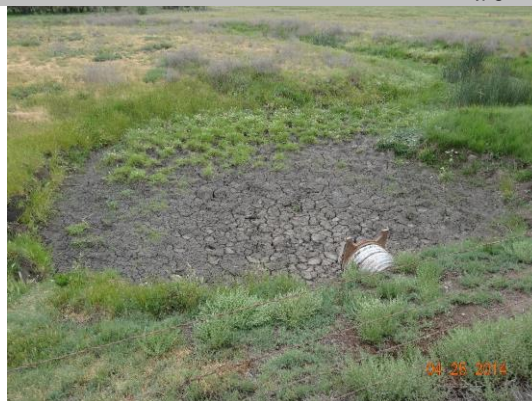
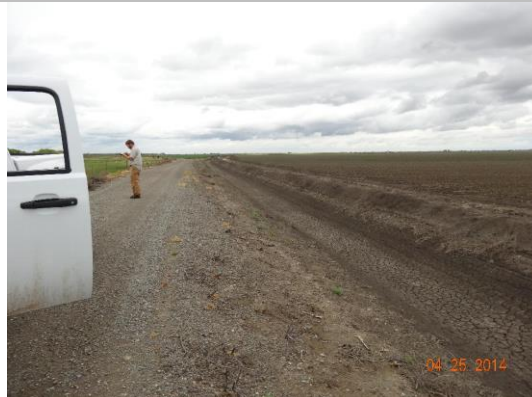
DS_ID:19605
FS_ID:61912
EP_NO: N/A
Repair Type: Non-Urgent
EVAL Issue:
Crossing Status: Found
UCIP Comments: 04/25/2014 Non-functional crossing--landward side is buried. Need to contact owner to determine status. If crossing is no longer used need to coordinate with CVFPB for proper abandonment. (O. Magana - DWR UCIP)
FIELD_STRUCT_DESC: 24-inch corrugated metal gravity drainage pipe through the levee, 9 feet below the crown. Flap gate on the waterside (WS) end. Wooden headboards on the landside (LS) end. Brass cap No. 31 bench mark (BM) on the headwall on the LS.
[Additional Reference(s): DWR Levee Log, 2002 (HLM 22.13), listed as a 24-inch corrugated metal pipe (CMP). USACE San Joaquin O&M Manual, Unit 601 Part 1 (SJR601.1), 1967, Revised 25 May 2011, (HLM 22.13), listed as a 24-inch CMP].
FS Date: 4/25/2014

View of waterward side.

Flap gate visible on waterward side.

View of landward side.

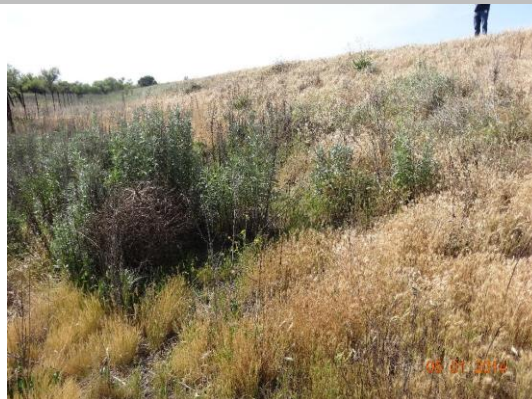
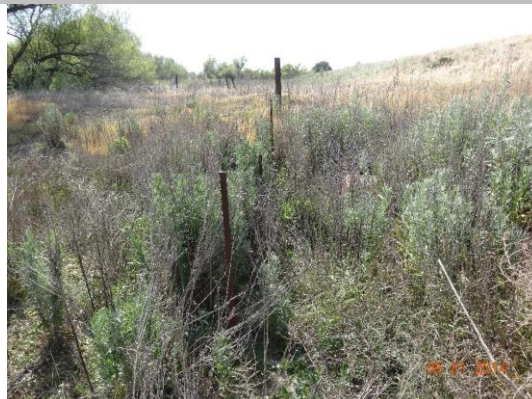
DS_ID:19652
FS_ID:61974
EP_NO: N/A
Repair Type: Non-Urgent
EVAL Issue:
Crossing Status: Found
UCIP Comments: 05/01/2014 Dense vegetation limits the inspector's visibility to identify signs of pipe failure (leaks) along the slope. Recommend removing vegetation along pipe alignment to conduct proper inspection of structure. (O. Magana - DWR UCIP)
FIELD_STRUCT_DESC: 24-inch corrugated metal gravity drainage pipe through the levee, 11 feet below the crown. Flap gate on the waterside (WS) end. Brass cap No. 139 bench mark (BM) on the headwall on the landside (LS). [Additional Reference(s): DWR Levee Log, 2002 (HLM 0.24), listed as a 24-inch corrugated metal pipe (CMP). USACE San Joaquin O&M Manual, Unit 601 Part 1 (SJR 601.1), 1967, Revised 25 May 2011, (HLM 0.24), listed as a 24-inch CMP].
FS Date: 5/1/2014

View of waterward side.

Fence along waterward side. No headwall was found on waterward side.

View of landward side.

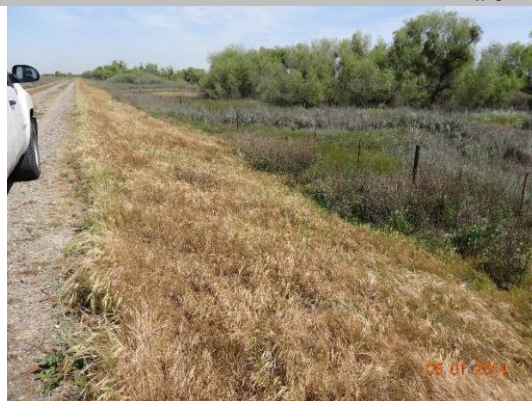
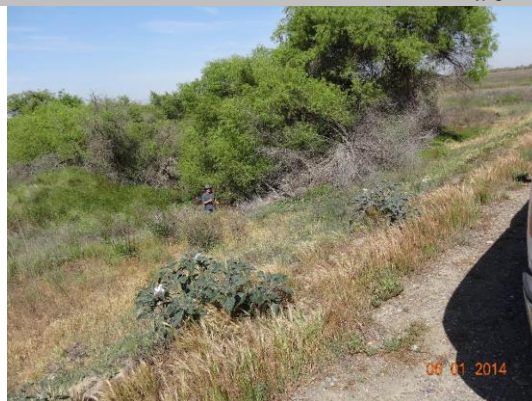
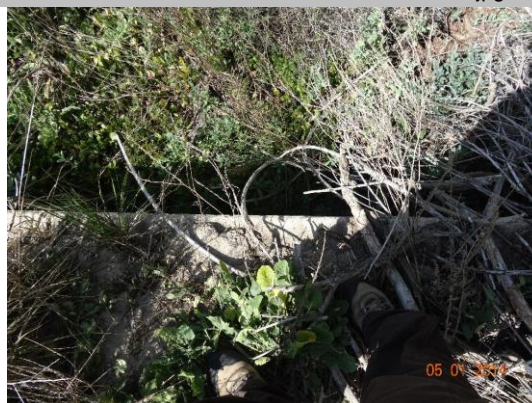
DS_ID:19653
 FS_ID:61976
 EP_NO: N/A
 Repair Type: Non-Urgent
 EVAL Issue:
 Crossing Status: Found
 UCIP Comments: 05/01/2014 Dense vegetation limits the inspector's visibility to identify signs of pipe failure (leaks) along the slope. Recommend removing vegetation along pipe alignment to conduct proper inspection of structure. (O. Magana - DWR UCIP)
 FIELD_STRUCT_DESC: 24-inch corrugated metal gravity drainage pipe through the levee, 14.8 feet below the crown. Flap gate on the waterside (WS) end. Brass cap No. 138 bench mark (BM) on the headwall on the landside (LS). [Additional Reference(s): DWR Levee Log, 2002 (HLM 0.69), listed as a 24-inch corrugated metal pipe (CMP). USACE San Joaquin O&M Manual, Unit 601 Part 1 (SJR 601.1), 1967, Revised 25 May 2011, (HLM 0.67), listed as a 24-inch CMP].
 FS Date: 5/1/2014

View of waterward side.

View of landward side.

Concrete headwall found on landward side.

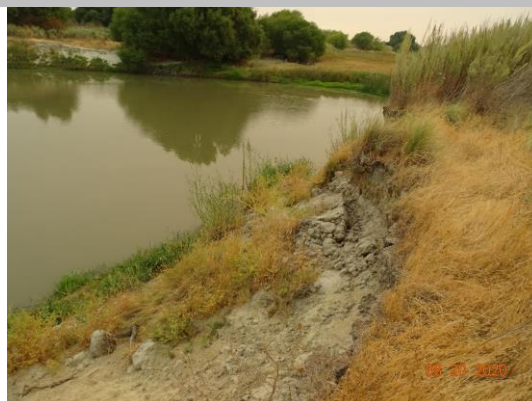
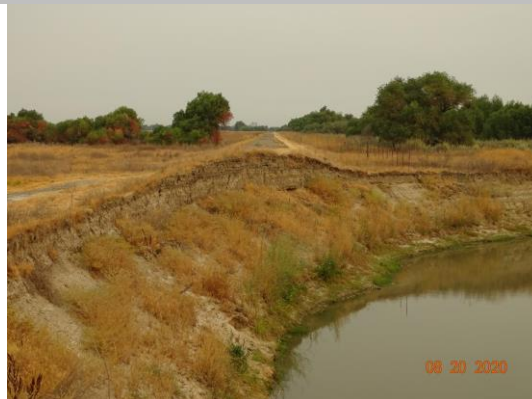
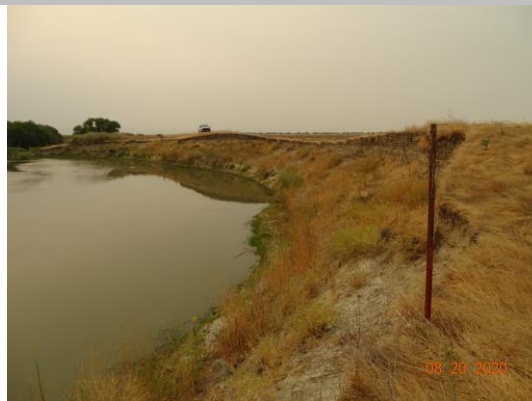
| 08/20/2020: This site was discovered during the DWR Spring 2012 Levee Inspections. A 250-ft long levee section has completely eroded away and no longer provides adequate flood protection. Note: Unit 2A is in the process of being turned over to State Parks. | | | | | |

8/20/2020: View of the upstream end of the erosion looking upstream.

8/20/2020: View of the eroded levee section looking downstream.

8/20/2020: View of the eroded levee section looking upstream.

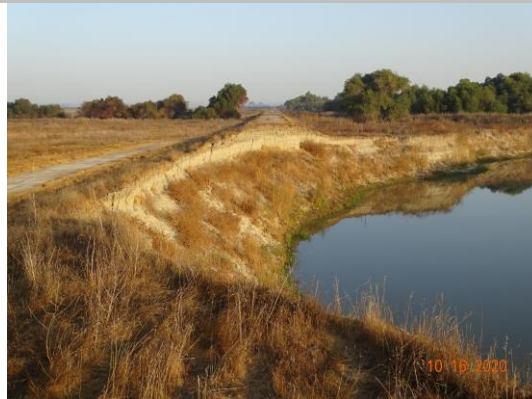
Photo 1 of 1 : FA_2020_NA0010_119_5_20201019_00060.jpg

| This section of the levee unit is in the process of being turned over to State Parks. | | | | | |

Looking downstream at erosion through the waterside slope and crown.
(Fall 2020)

| E2 : Schedule repair of erosion site prior to the next inspection. | | | | | |
