Flood Control Project Maintenance Levee Inspections

Fall 2020 Levee Maintenance Deficiency Summary Report

San Joaquin River Basin

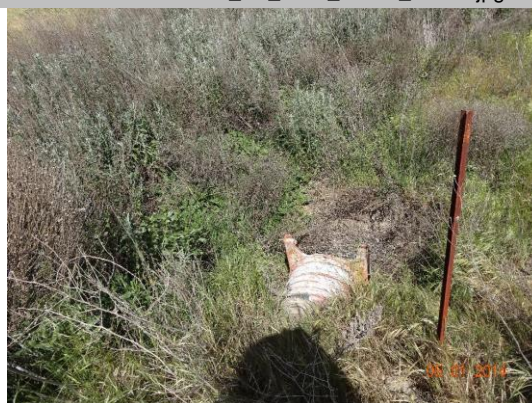
Photo 2 of 3 : UCIP_FA_2020_61977_66112.jpg

Pipe visible on waterward side.

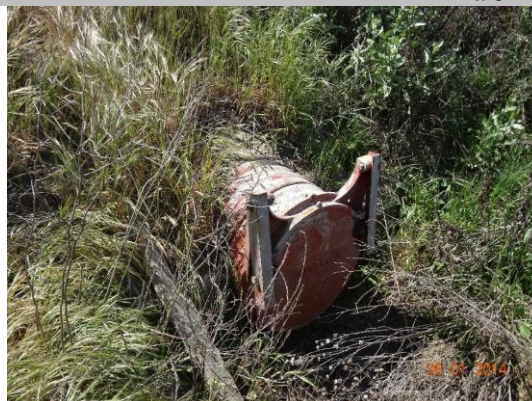
Photo 3 of 3 : UCIP_FA_2020_61977_66111.jpg

Flap gate visible on waterward side.

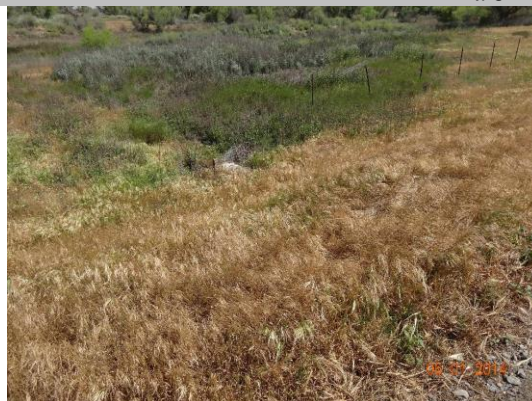
Photo 1 of 3 : UCIP_FA_2020_61979_66114.jpg

DS_ID:19655
 FS_ID:61979
 EP_NO: N/A
 Repair Type: Non-Urgent
 EVAL Issue:
 Crossing Status: Found
 UCIP Comments: 05/01/2014 Dense vegetation limits the inspector's visibility to identify signs of pipe failure (leaks) along the slope. Recommend removing vegetation along pipe alignment to conduct proper inspection of structure. (O. Magana - DWR UCIP)
 FIELD_STRUCT_DESC: 24-inch corrugated metal gravity drainage pipe through the levee, 8.6 feet below the crown. Flap gate on the waterside (WS) end. Brass cap No. 136 bench mark (BM) on the headwall on the landside (LS). [Additional Reference(s): DWR Levee Log, 2002 (HLM 1.23), listed as a 24-inch corrugated metal pipe (CMP). USACE San Joaquin O&M Manual, Unit 601 Part 1 (SJR 601.1), 1967, Revised 25 May 2011, (HLM 1.22), listed as a 24-inch CMP].
 FS Date: 5/1/2014

Overview of waterward side.

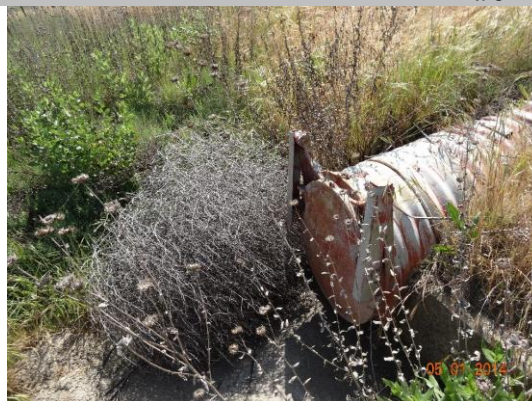
Photo 2 of 3 : UCIP_FA_2020_61979_66117.jpg

Flap gate visible on waterward side.

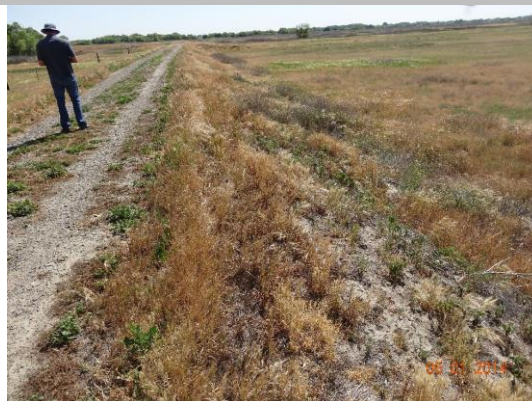
Photo 3 of 3 : UCIP_FA_2020_61979_66116.jpg

View of landward side.

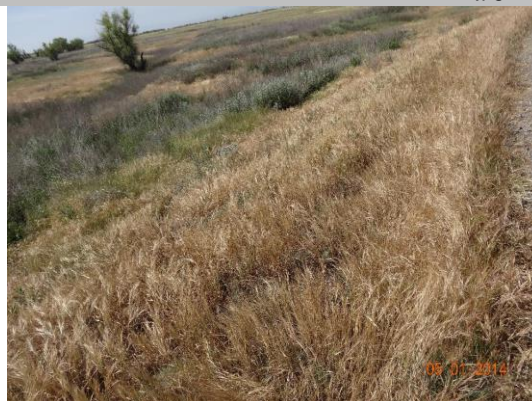
Photo 1 of 3 : UCIP_FA_2020_62000_66120.jpg

DS_ID:19656
FS_ID:62000
EP_NO: N/A
Repair Type: Non-Urgent
EVAL Issue:
Crossing Status: Found
UCIP Comments: 05/01/2014 Dense vegetation limits the inspector's visibility to identify signs of pipe failure (leaks) along the slope. Recommend removing vegetation along pipe alignment to conduct proper inspection of structure. (O. Magana - DWR UCIP)
FIELD_STRUCT_DESC: 36-inch corrugated metal gravity drainage pipe through the levee, 14.6 feet below the crown. Flap gate on the waterside (WS) end. Brass cap No. 135 bench mark (BM) on the headwall on the landside (LS). [Additional Reference(s): DWR Levee Log, 2002 (HLM 1.36), listed as a 36-inch corrugated metal pipe (CMP). USACE San Joaquin O&M Manual, Unit 601 Part 1 (SJR 601.1), 1967, Revised 25 May 2011, (HLM 1.34), listed as a 36-inch CMP].
FS Date: 5/1/2014

View of landward side.

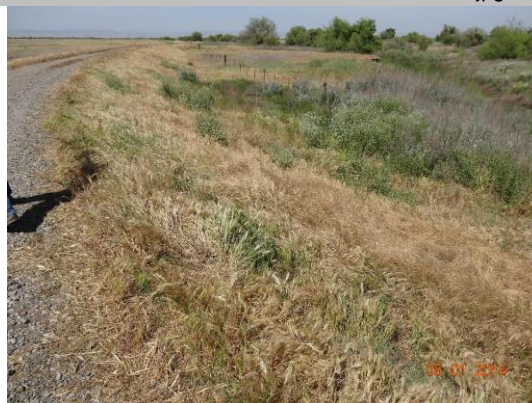
Photo 2 of 3 : UCIP_FA_2020_62000_66119.jpg

View of waterward side.

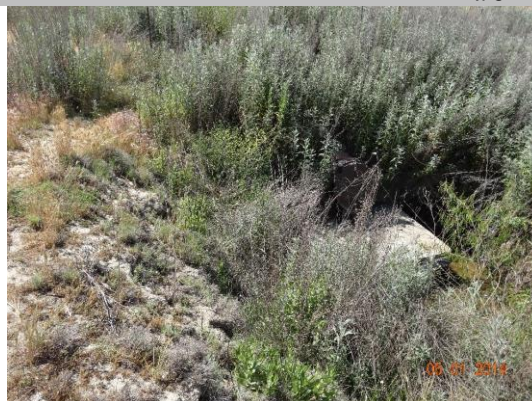
Photo 3 of 3 : UCIP_FA_2020_62000_66118.jpg

Flap gate and concrete apron visible on waterward side.

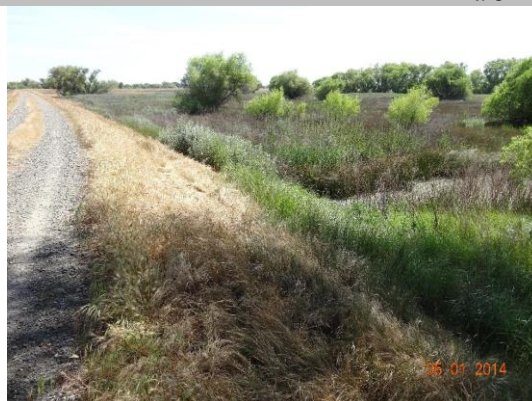
Photo 1 of 3 : UCIP_FA_2020_61981_66124.jpg

DS_ID:19657
 FS_ID:61981
 EP_NO: N/A
 Repair Type: Non-Urgent
 EVAL Issue:
 Crossing Status: Found
 UCIP Comments: 05/01/2014 Dense vegetation limits the inspector's visibility to identify signs of pipe failure (leaks) along the slope. Recommend removing vegetation along pipe alignment to conduct proper inspection of structure. (O. Magana - DWR UCIP)
 FIELD_STRUCT_DESC: 24-inch corrugated metal gravity drainage pipe through the levee, 10.2 feet below the crown. Flap gate on the waterside (WS) end. Brass cap No. 135 bench mark (BM) on the headwall on the landside (LS). [Additional Reference(s): DWR Levee Log, 2002 (HLM 1.63), listed as a 24-inch corrugated metal pipe (CMP). USACE San Joaquin O&M Manual, Unit 601 Part 1 (SJR 601.1), 1967, Revised 25 May 2011, (HLM 1.62), listed as a 24-inch CMP].
 FS Date: 5/1/2014

Overview of landward side.

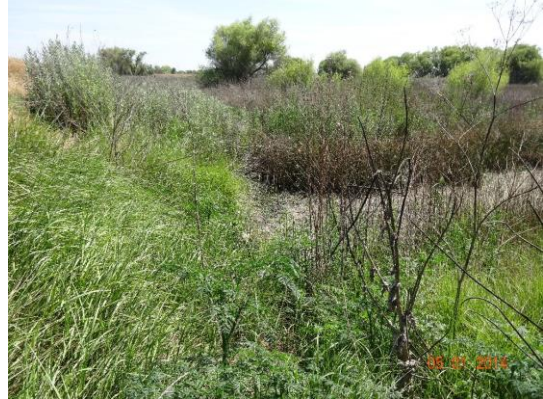
Photo 2 of 3 : UCIP_FA_2020_61981_66123.jpg

Dense vegetation along levee slope and toe.

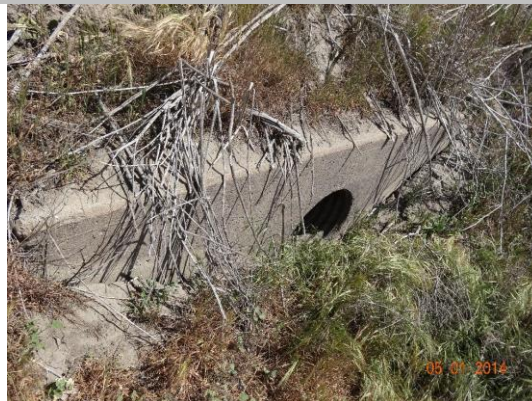
Photo 2 of 3 : UCIP_FA_2020_61982_66128.jpg

Concrete headwall visible on landward side.

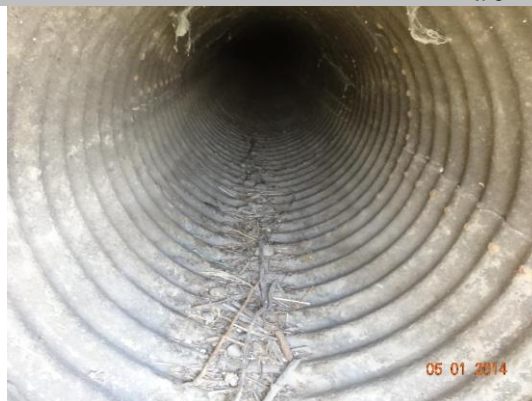
Photo 3 of 3 : UCIP_FA_2020_61982_66127.jpg

Inside view of pipe from landward side.

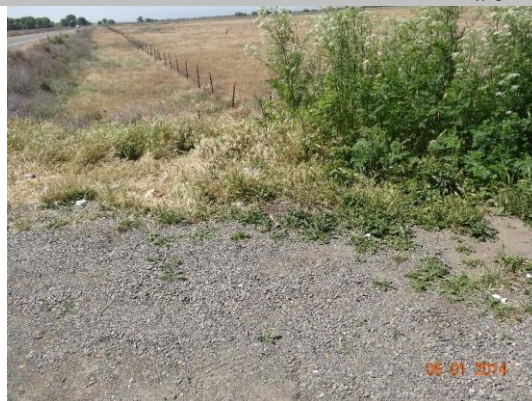
Photo 1 of 3 : UCIP_FA_2020_61984_66133.jpg

DS_ID:19659
 FS_ID:61984
 EP_NO: N/A
 Repair Type: Non-Urgent
 EVAL Issue:
 Crossing Status: Found
 UCIP Comments: 05/01/2014 Dense vegetation limits the inspector's visibility to identify signs of pipe failure (leaks) along the slope. Recommend removing vegetation along pipe alignment to conduct proper inspection of structure. (O. Magana - DWR UCIP)
 FIELD_STRUCT_DESC: 24-inch corrugated metal gravity drainage pipe through the levee, 7 feet below the crown. Flap gate on the waterside (WS) end. Brass cap No. 135 bench mark (BM) on the headwall on the landside (LS). [Additional Reference(s): DWR Levee Log, 2002 (HLM 2.32), listed as a 24-inch corrugated metal pipe (CMP). USACE San Joaquin O&M Manual, Unit 601 Part 1 (SJR 601.1), 1967, Revised 25 May 2011, (HLM 2.30), listed as a 24-inch CMP].
 FS Date: 5/1/2014

View of landward side.

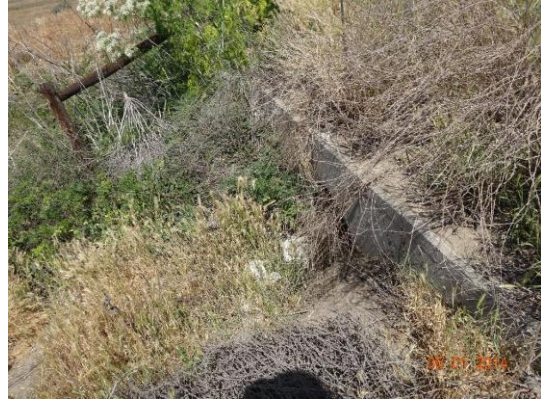
Photo 2 of 3 : UCIP_FA_2020_61984_66132.jpg

Concrete headwall visible on landward side.

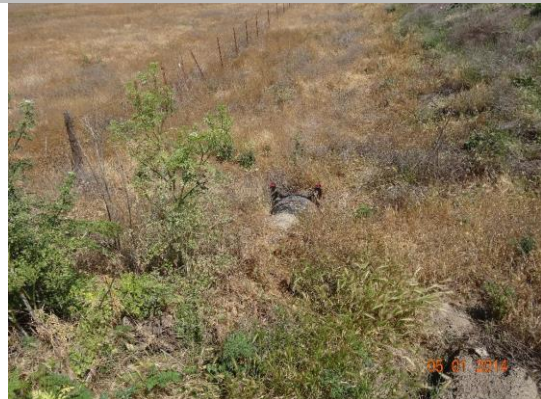
Photo 3 of 3 : UCIP_FA_2020_61984_66131.jpg

View of pipe through levee visible on waterward side.

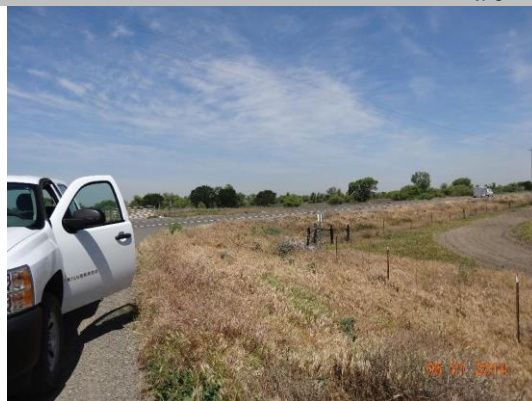
Photo 1 of 3 : UCIP_FA_2020_61985_66137.jpg

DS_ID:19660
FS_ID:61985
EP_NO: N/A
Repair Type: Non-Urgent
EVAL Issue:
Crossing Status: Found
UCIP Comments: 05/01/2014 Dense vegetation limits the inspector's visibility to identify signs of pipe failure (leaks) along the slope. Recommend removing vegetation along pipe alignment to conduct proper inspection of structure. (O. Magana - DWR UCIP)
FIELD_STRUCT_DESC: 24-inch corrugated metal gravity drainage pipe through the levee, 7 feet below the crown. Flap gate on the waterside (WS) end. Brass cap No. 135 bench mark (BM) on the headwall on the landside (LS). [Additional Reference(s): DWR Levee Log, 2002 (HLM 2.34), listed as a 24-inch corrugated metal pipe (CMP). USACE San Joaquin O&M Manual, Unit 601 Part 1 (SJR 601.1), 1967, Revised 25 May 2011, (HLM 2.32), listed as a 24-inch CMP].
FS Date: 5/1/2014

View of waterward side.

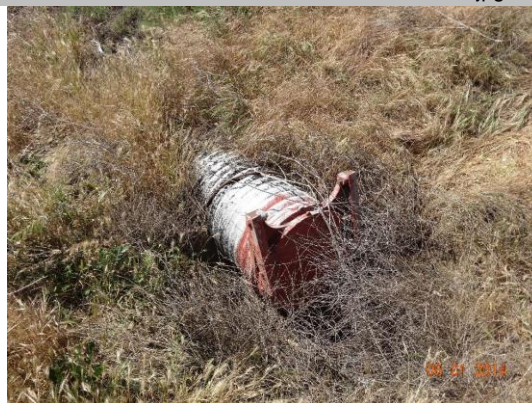
Photo 2 of 3 : UCIP_FA_2020_61985_66136.jpg

Flap gate visible on waterward side.

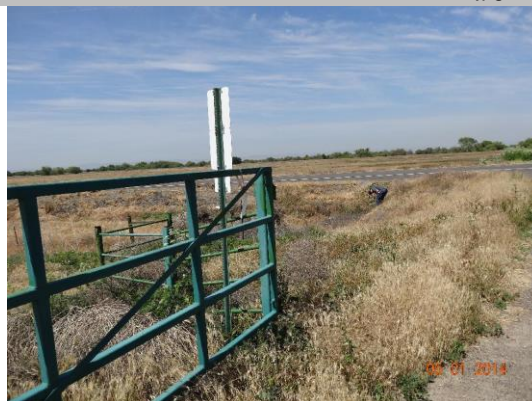
Photo 3 of 3 : UCIP_FA_2020_61985_66138.jpg

Overview of landward slope.

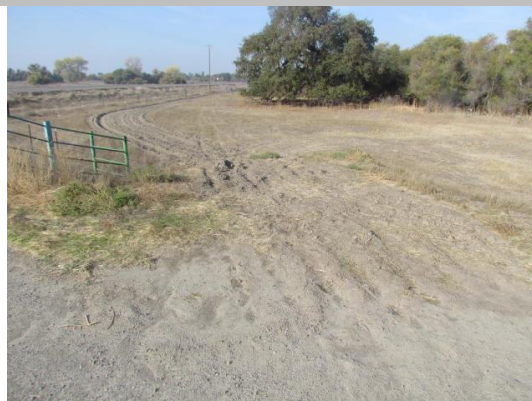
Photo 1 of 1 : FA_2020_NA0010_119_2_20200901_00001.jpg

| Unauthorized ramps are located on the landside and waterside slopes. | | | | | |

Looking northeast at unauthorized ramp on landward slope.

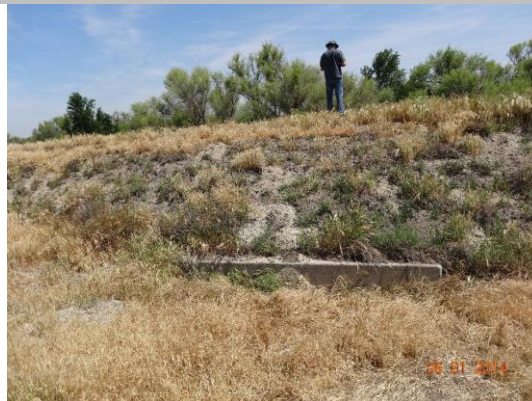
Photo 2 of 3 : UCIP_FA_2020_61986_66141.jpg

Concrete headwall visible on landward side.

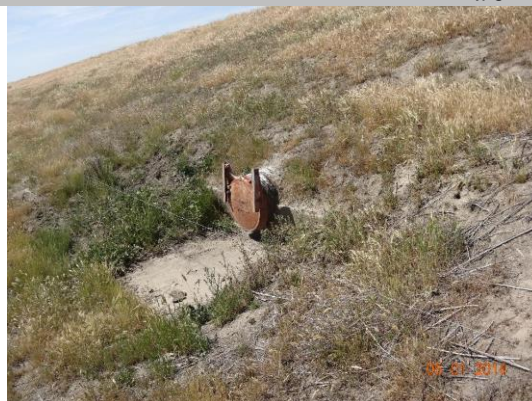
Photo 2 of 3 : UCIP_FA_2020_61987_66144.jpg

Flap gate visible on waterward side.

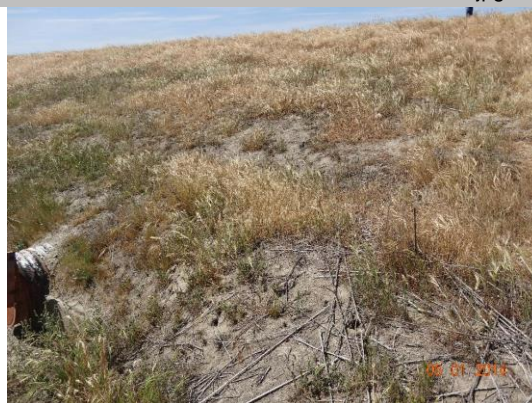
Photo 3 of 3 : UCIP_FA_2020_61987_66149.jpg

View of slope on waterward side.

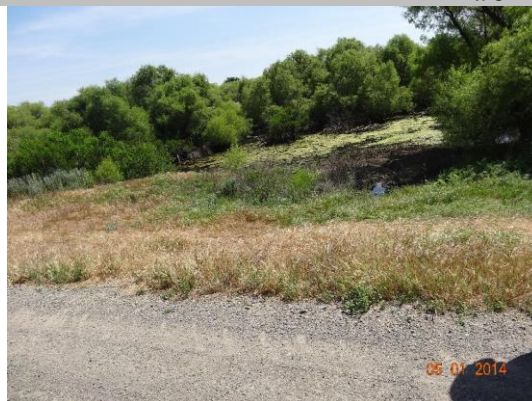
Photo 1 of 3 : UCIP_FA_2020_61988_66151.jpg

DS_ID:19665
FS_ID:61988
EP_NO: N/A
Repair Type: Non-Urgent
EVAL Issue:
Crossing Status: Found
UCIP Comments: 05/01/2014 Dense vegetation limits the inspector's visibility to identify signs of pipe failure (leaks) along the slope. Recommend removing vegetation along pipe alignment to conduct proper inspection of structure. (O. Magana - DWR UCIP)
FIELD_STRUCT_DESC: 24-inch corrugated metal gravity drainage pipe through the levee, 12.4 feet below the crown. Flap gate on the waterside (WS) end. Brass cap No. 130 bench mark (BM) on the headwall on the landside (LS). [Additional Reference(s): DWR Levee Log, 2002 (HLM 3.31), listed as a 24-inch corrugated metal pipe (CMP). USACE San Joaquin O&M Manual, Unit 601 Part 1 (SJR 601.1), 1967, Revised 25 May 2011, (HLM 3.29), listed as a 24-inch CMP].
FS Date: 5/1/2014

View of waterward side.

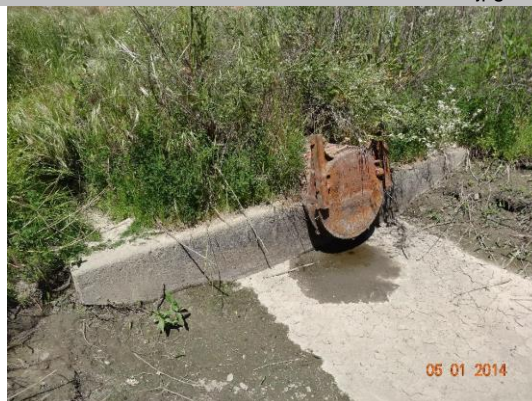
Photo 2 of 3 : UCIP_FA_2020_61988_66153.jpg

Flap gate visible on waterward side.

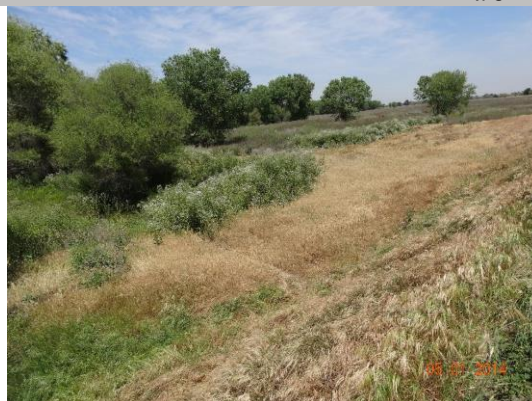
Photo 3 of 3 : UCIP_FA_2020_61988_66152.jpg

View of landward side.

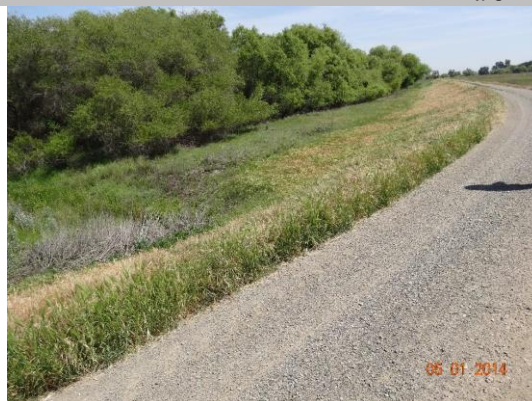
Photo 1 of 3 : UCIP_FA_2020_61989_66155.jpg

DS_ID:19666
 FS_ID:61989
 EP_NO: N/A
 Repair Type: Non-Urgent
 EVAL Issue:
 Crossing Status: Found
 UCIP Comments: 05/01/2014 Dense vegetation limits the inspector's visibility to identify signs of pipe failure (leaks) along the slope. Recommend removing vegetation along pipe alignment to conduct proper inspection of structure. (O. Magana - DWR UCIP)
 FIELD_STRUCT_DESC: 24-inch corrugated metal gravity drainage pipe through the levee, 10 feet below the crown. Flap gate on the waterside (WS) end. Brass cap No. 130 bench mark (BM) on the headwall on the landside (LS). [Additional Reference(s): DWR Levee Log, 2002 (HLM 3.63), listed as a 24-inch corrugated metal pipe (CMP). USACE San Joaquin O&M Manual, Unit 601 Part 1 (SJR 601.1), 1967, Revised 25 May 2011, (HLM 3.62), listed as a 24-inch CMP].
 FS Date: 5/1/2014

View of waterward side.

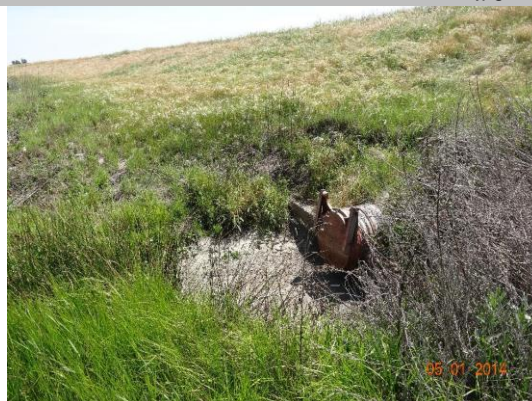
Photo 2 of 3 : UCIP_FA_2020_61989_66154.jpg

Flap gate visible on waterward side.

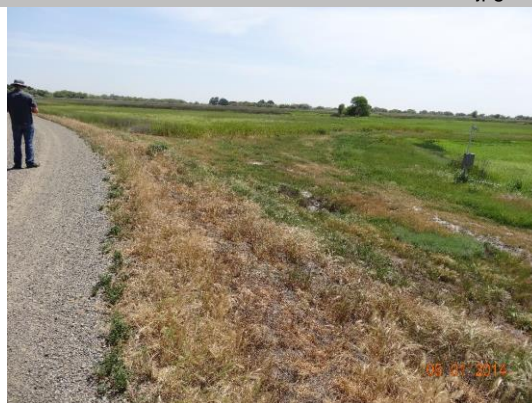
Photo 3 of 3 : UCIP_FA_2020_61989_66156.jpg

View of landward side.

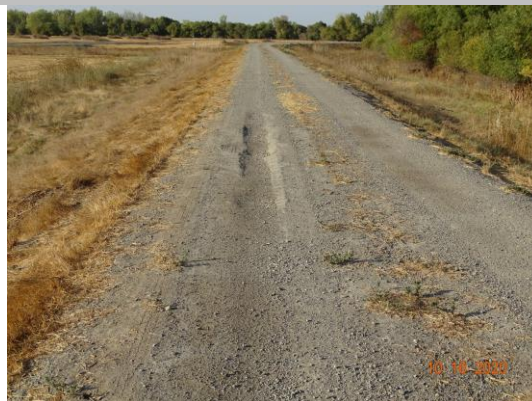
Photo 1 of 1 : FA_2020_NA0010_119_23_20201019_00061.jpg

Rutting along the levee crown. (Fall 2020)

| C2 : Repair depressions or ruts in the crown or slope. | | | | | |

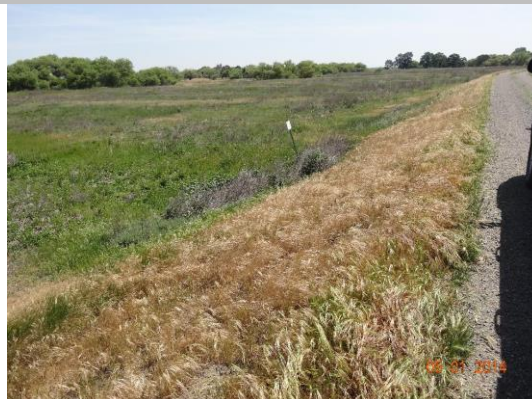
Photo 2 of 3 : UCIP_FA_2020_61990_66160.jpg

View of waterward side.

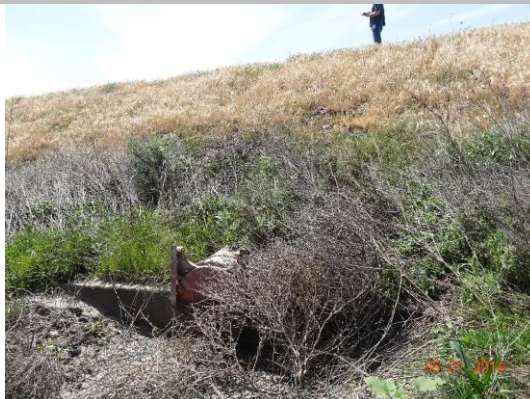
Photo 3 of 3 : UCIP_FA_2020_61990_66159.jpg

Flap gate and concrete headwall visible through dense vegetation.

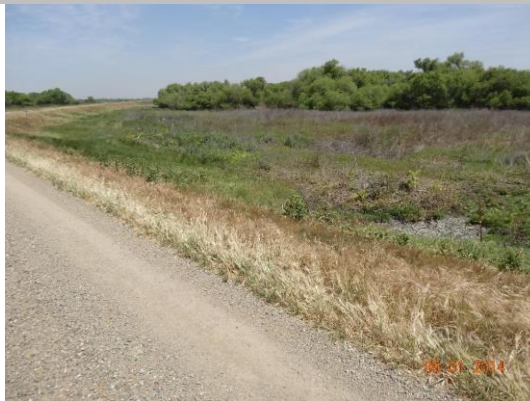
Photo 1 of 3 : UCIP_FA_2020_61992_66167.jpg

DS_ID:19668
 FS_ID:61992
 EP_NO: N/A
 Repair Type: Non-Urgent
 EVAL Issue:
 Crossing Status: Found
 UCIP Comments: 05/01/2014 Dense vegetation limits the inspector's visibility to identify signs of pipe failure (leaks) along the slope. Recommend removing vegetation along pipe alignment to conduct proper inspection of structure. (O. Magana - DWR UCIP)
 FIELD_STRUCT_DESC: 24-inch corrugated metal gravity drainage pipe through the levee, 8 feet below the crown. Flap gate on the waterside (WS) end. Brass cap No. 125 bench mark (BM) on the headwall on the landside (LS). [Additional Reference(s): DWR Levee Log, 2002 (HLM 5.45), listed as a 24-inch corrugated metal pipe (CMP). USACE San Joaquin O&M Manual, Unit 601 Part 1 (SJR 601.1), 1967, Revised 25 May 2011, (HLM 5.43), listed as a 24-inch CMP].
 FS Date: 5/1/2014

View of waterward side.

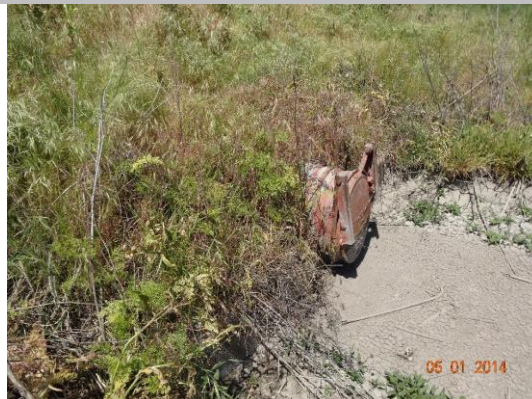
Photo 2 of 3 : UCIP_FA_2020_61992_66166.jpg

Flap gate visible on waterward side.

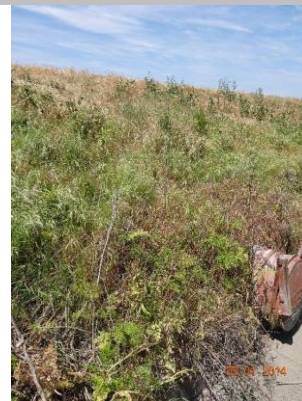
Photo 3 of 3 : UCIP_FA_2020_61992_66165.jpg

View of waterward slope covered by vegetation.

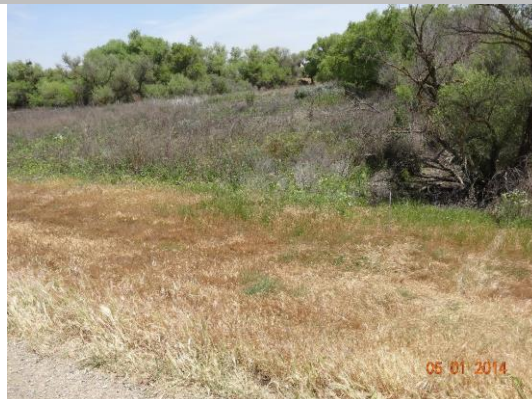
Photo 2 of 2 : UCIP_FA_2020_61993_66170.jpg

DS_ID:19669
FS_ID:61993
EP_NO: N/A
Repair Type: Non-Urgent
EVAL Issue:
Crossing Status: Found
UCIP Comments: 05/01/2014 Dense vegetation limits the inspector's visibility to identify signs of pipe failure (leaks) along the slope. Recommend removing vegetation along pipe alignment to conduct proper inspection of structure. (O. Magana - DWR UCIP)
FIELD_STRUCT_DESC: 24-inch corrugated metal gravity drainage pipe through the levee, 7.7 feet below the crown. Flap gate on the waterside (WS) end. Brass cap No. 125 bench mark (BM) on the headwall on the landside (LS). [Additional Reference(s): DWR Levee Log, 2002 (HLM 6.06), listed as a 24-inch corrugated metal pipe (CMP). USACE San Joaquin O&M Manual, Unit 601 Part 1 (SJR 601.1), 1967, Revised 25 May 2011, (HLM 6.06), listed as a 24-inch CMP].
FS Date: 5/1/2014

View of waterward side.

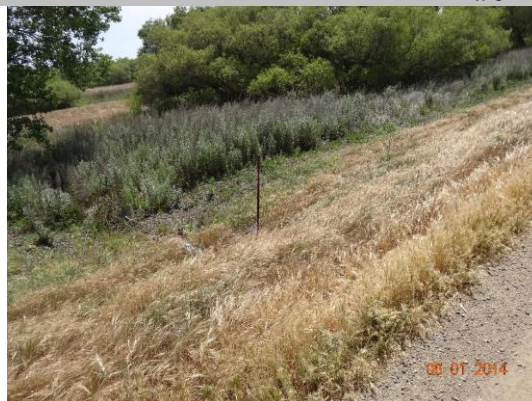
Photo 1 of 3 : UCIP_FA_2020_61994_66173.jpg

DS_ID:19670
FS_ID:61994
EP_NO: N/A
Repair Type: Non-Urgent
EVAL Issue:
Crossing Status: Found
UCIP Comments: 05/01/2014 Dense vegetation limits the inspector's visibility to identify signs of pipe failure (leaks) along the slope. Recommend removing vegetation along pipe alignment to conduct proper inspection of structure. (O. Magana - DWR UCIP)
FIELD_STRUCT_DESC: 24-inch corrugated metal gravity drainage pipe through the levee, 7.7 feet below the crown. Flap gate on the waterside (WS) end. Brass cap No. 125 bench mark (BM) on the headwall on the landside (LS). [Additional Reference(s): DWR Levee Log, 2002 (HLM 6.50), listed as a 24-inch corrugated metal pipe (CMP). USACE San Joaquin O&M Manual, Unit 601 Part 1 (SJR 601.1), 1967, Revised 25 May 2011, (HLM 6.50), listed as a 24-inch CMP].
FS Date: 5/1/2014

View of waterward side.

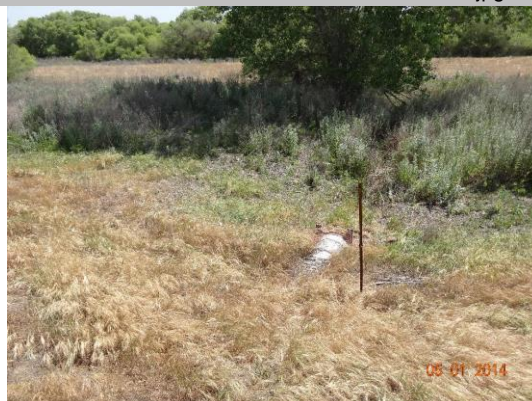
Photo 2 of 3 : UCIP_FA_2020_61994_66172.jpg

Crossing and flap gate visible on waterward side.

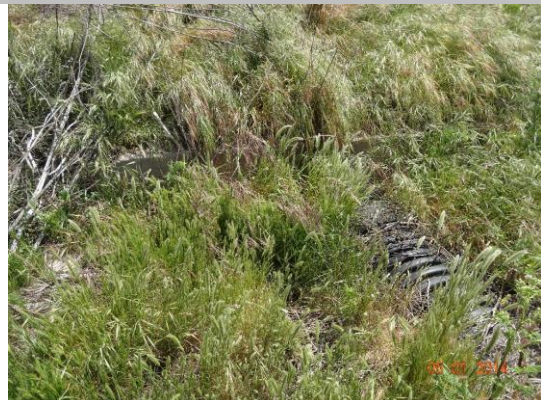
Photo 2 of 3 : UCIP_FA_2020_61995_66177.jpg

Pipe extension visible on landward side attached to inlet at concrete headwall.

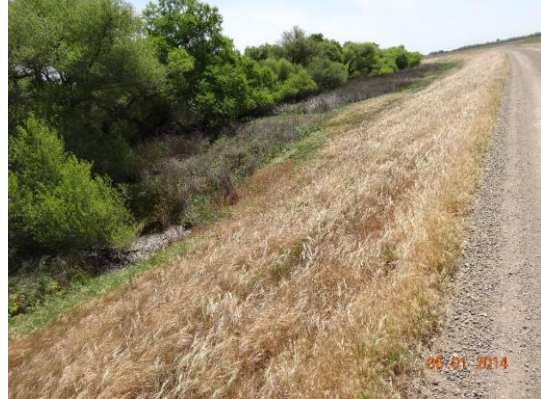
Photo 3 of 3 : UCIP_FA_2020_61995_66176.jpg

View of waterward side.

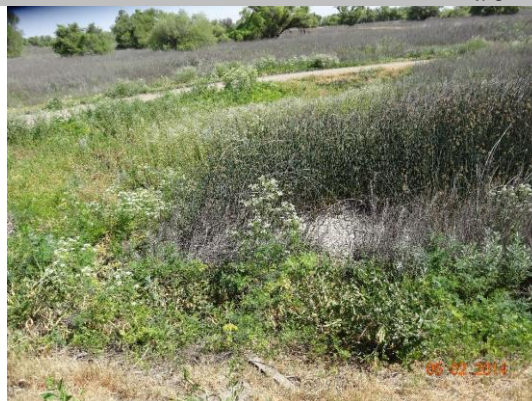
Photo 1 of 3 : UCIP_FA_2020_61997_66183.jpg

DS_ID:19673
FS_ID:61997
EP_NO: N/A
Repair Type: Non-Urgent
EVAL Issue:
Crossing Status: Found
UCIP Comments: 05/01/2014 Dense vegetation limits the inspector's visibility to identify signs of pipe failure (leaks) along the slope. Recommend removing vegetation along pipe alignment to conduct proper inspection of structure. (O. Magana - DWR UCIP)
FIELD_STRUCT_DESC: 24-inch corrugated metal gravity drainage pipe through the levee, 8 feet below the crown. Flap gate on the waterside (WS) end. Brass cap No. 125 bench mark (BM) on the headwall on the landside (LS). [Additional Reference(s): DWR Levee Log, 2002 (HLM 7.78), listed as a 24-inch corrugated metal pipe (CMP). USACE San Joaquin O&M Manual, Unit 601 Part 1 (SJR 601.1), 1967, Revised 25 May 2011, (HLM 7.77), listed as a 24-inch CMP].
FS Date: 5/1/2014

View of waterward side.

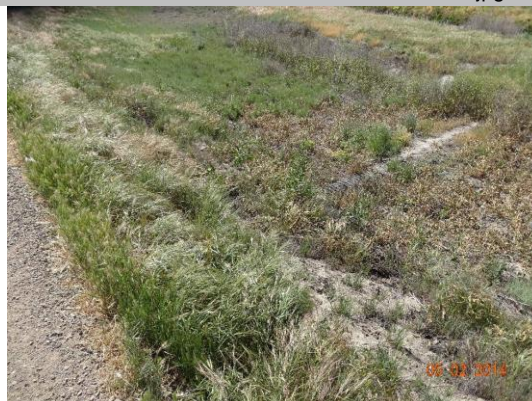
Photo 2 of 3 : UCIP_FA_2020_61997_66182.jpg

View of landward side.

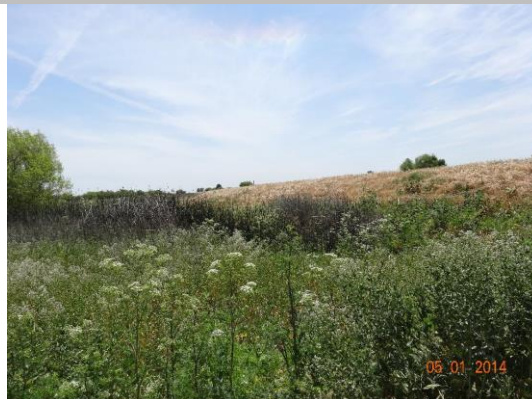
Photo 3 of 3 : UCIP_FA_2020_61997_66181.jpg

View of waterward side--photo taken from levee toe looking towards alignment of crossing.

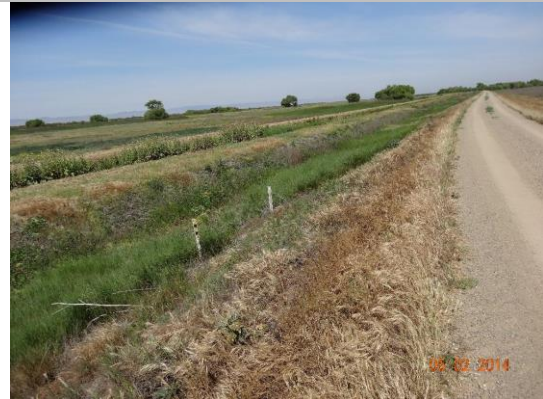
Photo 1 of 3 : UCIP_FA_2020_62001_66184.jpg

DS_ID:19674
 FS_ID:62001
 EP_NO: N/A
 Repair Type: Non-Urgent
 EVAL Issue:
 Crossing Status: Found
 UCIP Comments: 05/14/2014 Dense vegetation limits the inspector's visibility to identify signs of pipe failure (leaks) along the slope and landward headwall. Recommend removing vegetation along pipe alignment and toe to conduct proper inspection of structure. Sediment buildup in pipe visible from landward side--recommend clearing. (O. Magana - DWR UCIP)
 FIELD_STRUCT_DESC: 24-inch corrugated metal gravity drainage pipe through the levee, 9 feet below the crown. Flap gate on the waterside (WS) end. Brass cap No. 120 bench mark (BM) on the headwall on the landside (LS). [Additional Reference(s): DWR Levee Log, 2002 (HLM 8.17), listed as a 24-inch corrugated metal pipe (CMP). USACE San Joaquin O&M Manual, Unit 601 Part 1 (SJR 601.1), 1967, Revised 25 May 2011, (HLM 8.16), listed as a 24-inch CMP].
 FS Date: 5/14/2014

View of landward side.

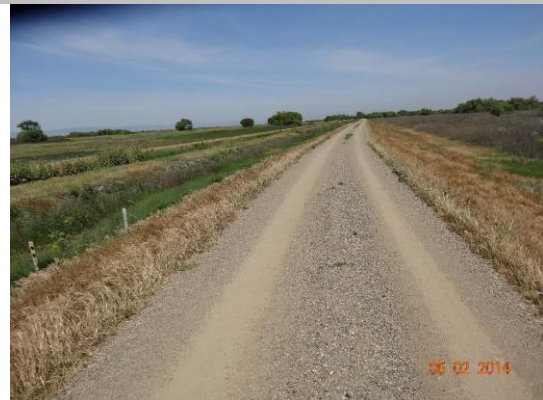
Photo 2 of 3 : UCIP_FA_2020_62001_66185.jpg

Overview of levee crown at crossing.

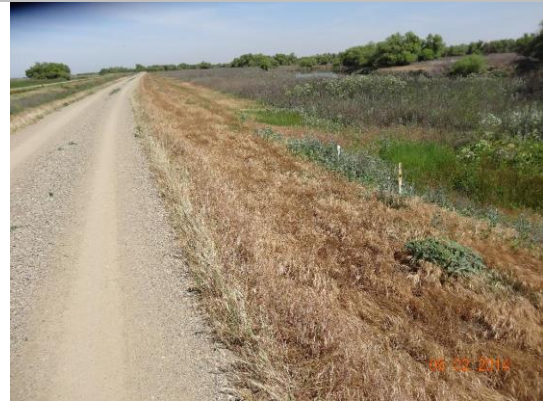
Photo 3 of 3 : UCIP_FA_2020_62001_66186.jpg

View of waterward side.

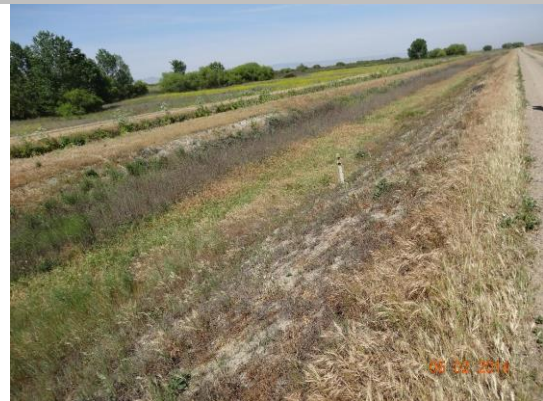
Photo 1 of 3 : UCIP_FA_2020_62003_66195.jpg

DS_ID:19675
 FS_ID:62003
 EP_NO: N/A
 Repair Type: Non-Urgent
 EVAL Issue:
 Crossing Status: Found
 UCIP Comments: 05/14/2014 Dense vegetation on landward toe. Also dense vegetation limits the inspector's visibility to identify signs of pipe failure (leaks) along waterward slope. Recommend removing vegetation along pipe alignment toe to conduct proper inspection of structure. Sediment buildup in pipe--recommend clearing. (O. Magana - DWR UCIP)
 FIELD_STRUCT_DESC: 24-inch corrugated metal gravity drainage pipe through the levee, 9.4 feet below the crown. Flap gate on the waterside (WS) end. Brass cap No. 120 bench mark (BM) on the headwall on the landside (LS). [Additional Reference(s): DWR Levee Log, 2002 (HLM 8.49), listed as a 24-inch corrugated metal pipe (CMP). USACE San Joaquin O&M Manual, Unit 601 Part 1 (SJR 601.1), 1967, Revised 25 May 2011, (HLM 8.48), listed as a 24-inch CMP].
 FS Date: 5/14/2014

View of landward side.

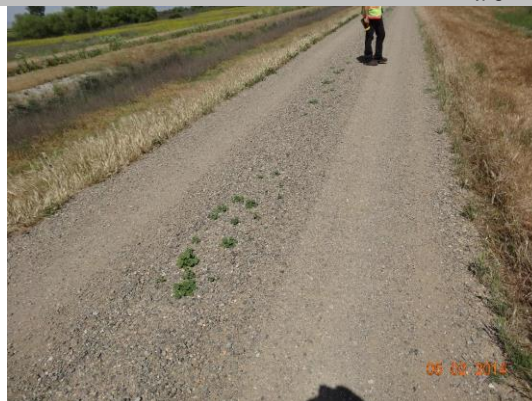
Photo 2 of 3 : UCIP_FA_2020_62003_66193.jpg

Overview of levee crown at crossing.

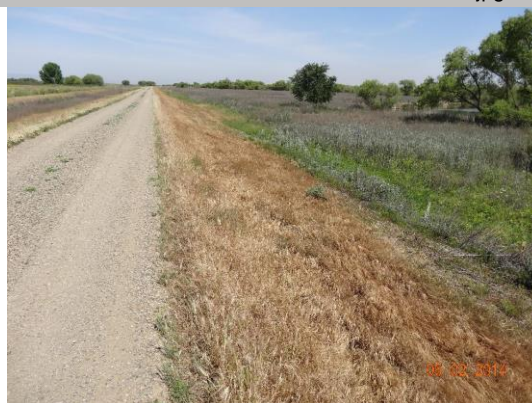
Photo 3 of 3 : UCIP_FA_2020_62003_66194.jpg

View of waterward side.

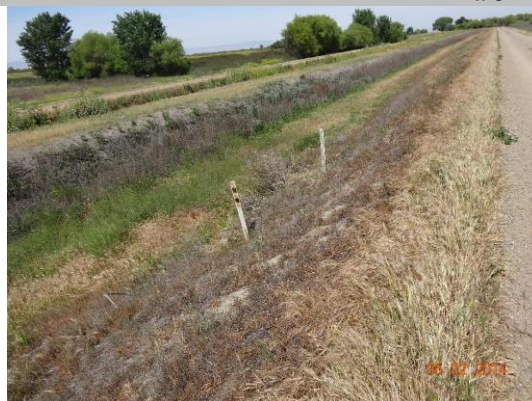
Photo 1 of 3 : UCIP_FA_2020_62004_66200.jpg

DS_ID:19676
FS_ID:62004
EP_NO: N/A
Repair Type: Non-Urgent
EVAL Issue:
Crossing Status: Found
UCIP Comments: 05/14/2014 Dense vegetation limits the inspector's visibility to identify signs of pipe failure (leaks) along the slope. Recommend removing vegetation along pipe alignment to conduct proper inspection of structure. Burrow activity present on waterward slope. (O. Magana - DWR UCIP)
FIELD_STRUCT_DESC: 24-inch corrugated metal gravity drainage pipe through the levee, 8.8 feet below the crown. Flap gate on the waterside (WS) end. Brass cap No. 120 bench mark (BM) on the headwall on the landside (LS). [Additional Reference(s): DWR Levee Log, 2002 (HLM 8.88), listed as a 24-inch corrugated metal pipe (CMP). USACE San Joaquin O&M Manual, Unit 601 Part 1 (SJR 601.1), 1967, Revised 25 May 2011, (recorded as HLM 9.86 should be HLM 8.86), listed as a 24-inch CMP].
FS Date: 5/14/2014

View of landward side.

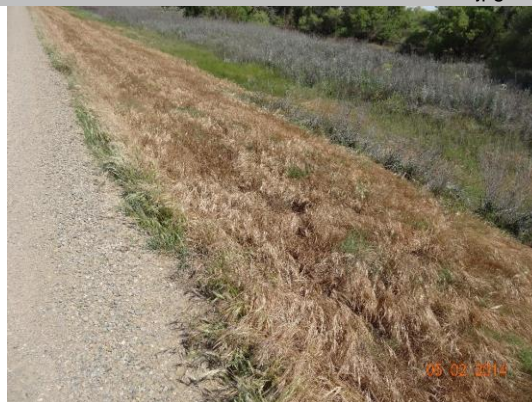
Photo 2 of 3 : UCIP_FA_2020_62004_66199.jpg

View of waterward side.

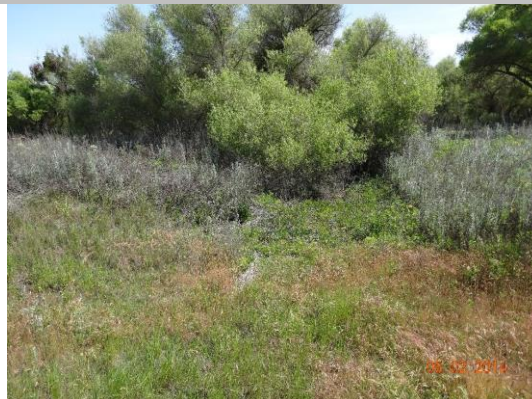
Photo 3 of 3 : UCIP_FA_2020_62004_66201.jpg

View of waterward toe.

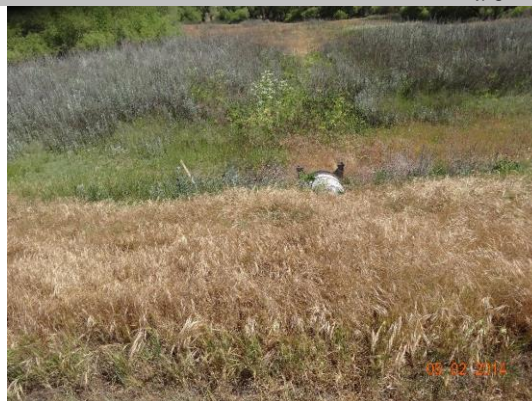
Photo 1 of 3 : UCIP_FA_2020_62005_66208.jpg

DS_ID:19677
 FS_ID:62005
 EP_NO: N/A
 Repair Type: Non-Urgent
 EVAL Issue:
 Crossing Status: Found
 UCIP Comments: 05/14/2014 Dense vegetation limits the inspector's visibility to identify signs of pipe failure (leaks) along the slope. Recommend removing vegetation along pipe alignment to conduct proper inspection of structure. (O. Magana - DWR UCIP)
 FIELD_STRUCT_DESC: 36-inch corrugated metal gravity drainage pipe through the levee, 8.8 feet below the crown. Flap gate on the waterside (WS) end. Brass cap No. 120 bench mark (BM) on the headwall on the landside (LS). [Additional Reference(s): DWR Levee Log, 2002 (HLM 9.03), listed as a 36-inch corrugated metal pipe (CMP). USACE San Joaquin O&M Manual, Unit 601 Part 1 (SJR 601.1), 1967, Revised 25 May 2011, (HLM 9.02), listed as a 36-inch CMP].
 FS Date: 5/14/2014

View of waterward side--pipe and flap gate visible.

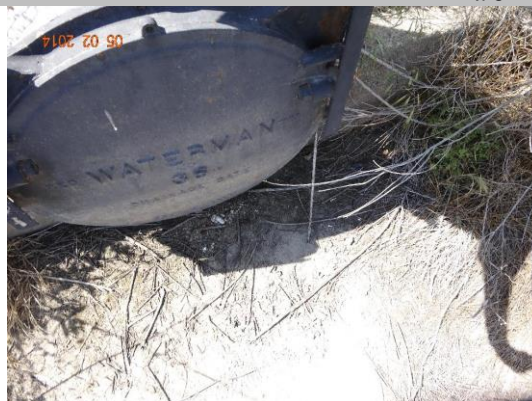
Photo 2 of 3 : UCIP_FA_2020_62005_66207.jpg

View of flap gate visible from waterward side.

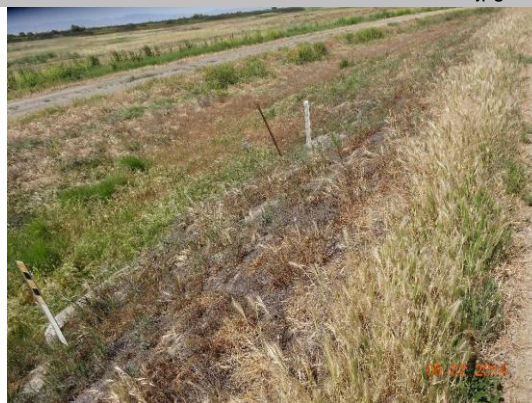
Photo 3 of 3 : UCIP_FA_2020_62005_66206.jpg

View of landward side.

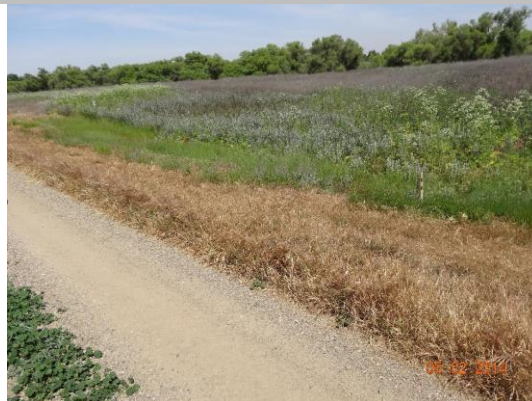
Photo 2 of 3 : UCIP_FA_2020_62006_66210.jpg

View of waterward side.

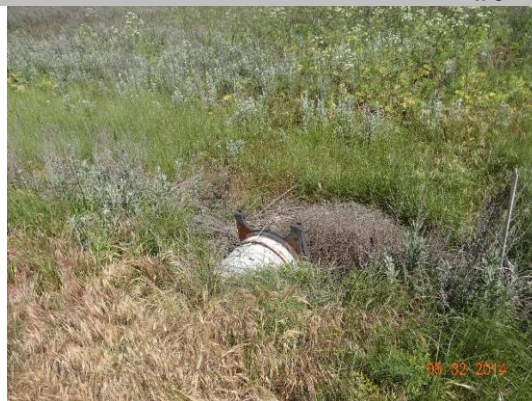
Photo 3 of 3 : UCIP_FA_2020_62006_66209.jpg

Pipe visible on waterward side.

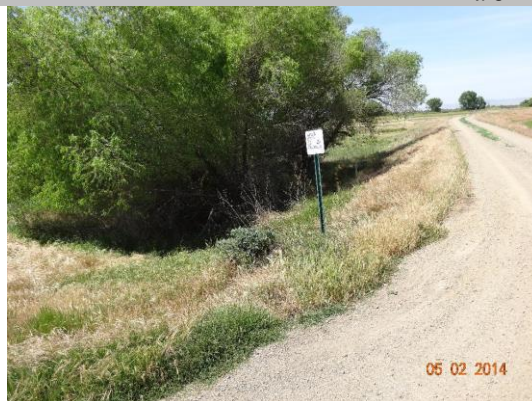
Photo 1 of 3 : UCIP_FA_2020_62008_66217.jpg

DS_ID:19686
 FS_ID:62008
 EP_NO: N/A
 Repair Type: Non-Urgent
 EVAL Issue:
 Crossing Status: Found
 UCIP Comments: 05/14/2014 Dense vegetation limits the inspector's visibility to identify signs of pipe failure (leaks) along the slope. Recommend removing vegetation along pipe alignment to conduct proper inspection of structure. (O. Magana - DWR UCIP)
 FIELD_STRUCT_DESC: 24-inch corrugated metal gravity drainage pipe through the levee, 9 feet below the crown. Flap gate on the waterside (WS) end. Brass cap No. 115 bench mark (BM) on the headwall on the landside (LS). [Additional Reference(s): DWR Levee Log, 2002 (HLM 9.47), listed as a 24-inch corrugated metal pipe (CMP). USACE San Joaquin O&M Manual, Unit 601 Part 1 (SJR 601.1), 1967, Revised 25 May 2011, (HLM 9.46), listed as a 24-inch CMP].
 FS Date: 5/14/2014

View of landward side.

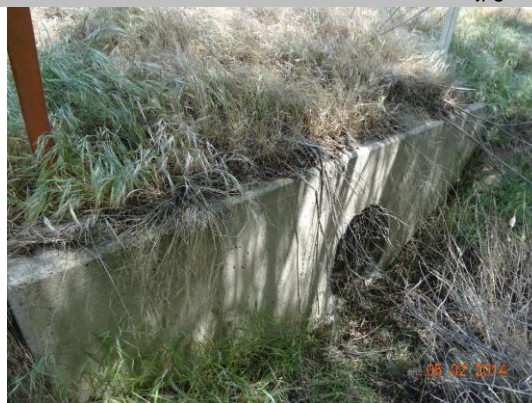
Photo 3 of 3 : UCIP_FA_2020_62008_66215.jpg

Concrete headwall visible on landward side.

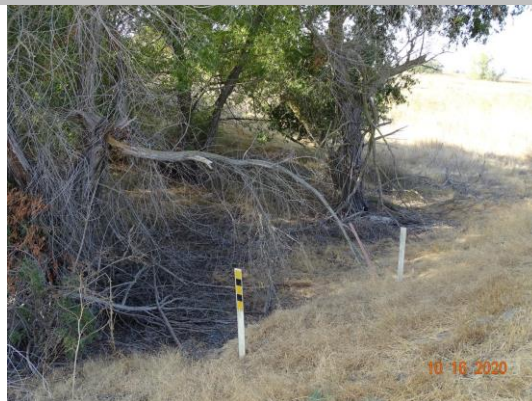
Photo 1 of 1 : FA_2020_NA0010_120_16_20201022_00040.jpg

| Broken tree branches hanging on the landside slope. | | | | | |

Broken tree limbs on the landside slope and toe. (Fall 2020)

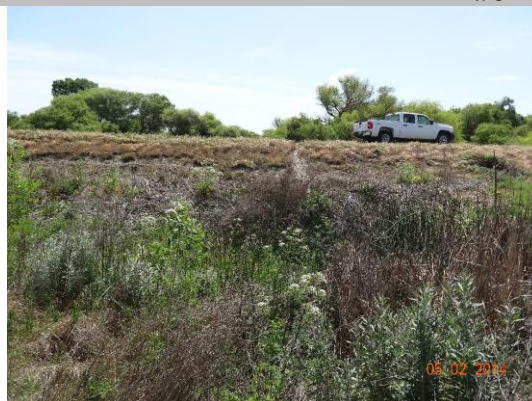
Photo 2 of 3 : UCIP_FA_2020_62009_66226.jpg

View of waterward slope.

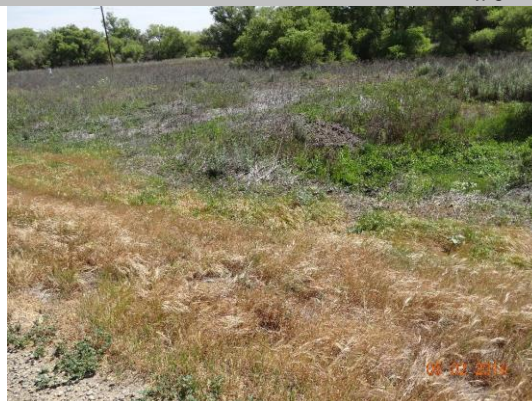
Photo 3 of 3 : UCIP_FA_2020_62009_66222.jpg

View of waterward side.

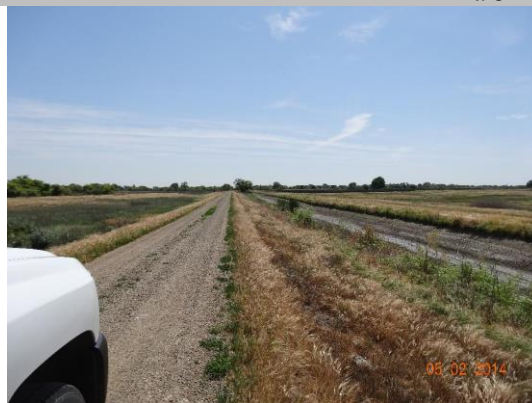
Photo 1 of 3 : UCIP_FA_2020_62010_66231.jpg

DS_ID:19688
 FS_ID:62010
 EP_NO: N/A
 Repair Type: Non-Urgent
 EVAL Issue:
 Crossing Status: Found
 UCIP Comments: 05/14/2014 Dense vegetation limits the inspector's visibility to identify signs of pipe failure (leaks) along the slope. Recommend removing vegetation along pipe alignment to conduct proper inspection of structure. Sediment buildup in pipe visible on landward side--recommend clearing. (O. Magana - DWR UCIP)
 FIELD_STRUCT_DESC: 24-inch corrugated metal gravity drainage pipe through the levee, 8 feet below the crown. Flap gate on the waterside (WS) end. Brass cap No. 115 bench mark (BM) on the headwall on the landside (LS). [Additional Reference(s): DWR Levee Log, 2002 (HLM 10.82), listed as a 24-inch corrugated metal pipe (CMP). USACE San Joaquin O&M Manual, Unit 601 Part 1 (SJR 601.1), 1967, Revised 25 May 2011, (HLM 10.81), listed as a 24-inch CMP].
 FS Date: 5/14/2014

View of landward side.

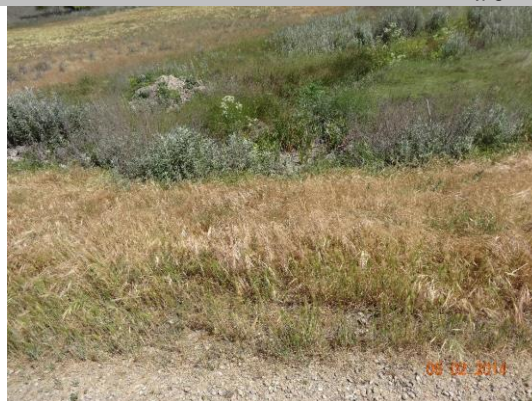
Photo 2 of 3 : UCIP_FA_2020_62010_66232.jpg

View of waterward side.

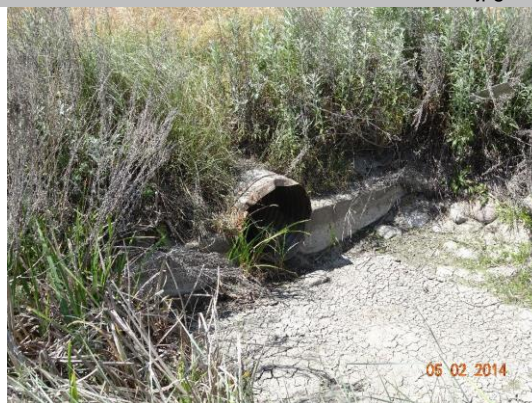
Photo 3 of 3 : UCIP_FA_2020_62010_66234.jpg

View of pipe visible on waterward side.

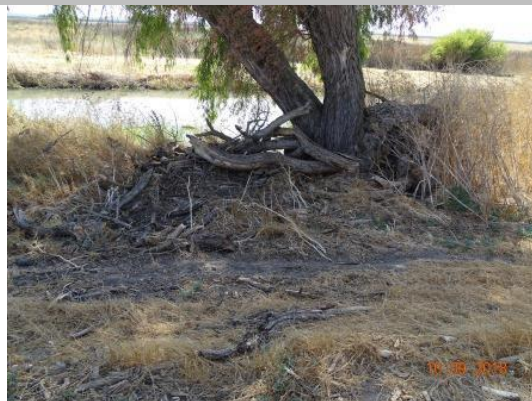
Photo 1 of 1 : FA_2020_NA0010_120_14_20200901_00002.jpg

Prunings at landside toe. (Fall 2018)

| Remove prunings from landside toe. | | | | | |

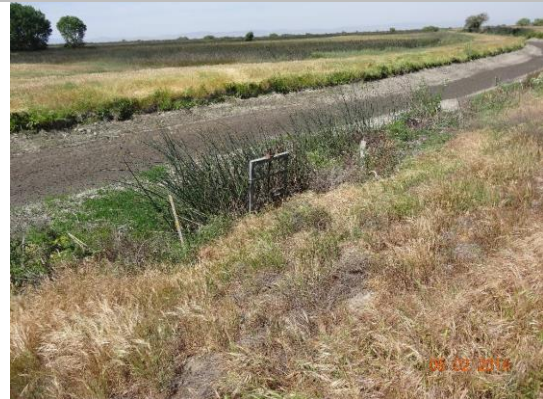
Photo 1 of 3 : UCIP_FA_2020_62012_66236.jpg

| DS_ID:19689 FS_ID:62012 EP_NO: N/A Repair Type: Non-Urgent EVAL Issue: Crossing Status: Found UCIP Comments: 05/14/2014 Dense vegetation limits the inspector's visibility to identify signs of pipe failure (leaks) along the slope. Recommend removing vegetation along pipe alignment to conduct proper inspection of structure. (O. Magana - DWR UCIP) FIELD_STRUCT_DESC: 24-inch corrugated metal gravity drainage pipe through the levee, 8 feet below the crown. Flap gate on the waterside (WS) end. Brass cap No. 115 bench mark (BM) on the headwall on the landside (LS). [Additional Reference(s): DWR Levee Log, 2002 (HLM 11.18), listed as a 24-inch corrugated metal pipe (CMP). USACE San Joaquin O&M Manual, Unit 601 Part 1 (SJR 601.1), 1967, Revised 25 May 2011, (HLM 11.17), listed as a 24-inch CMP]. FS Date: 5/14/2014 | | | | | | |

View of landward slope.

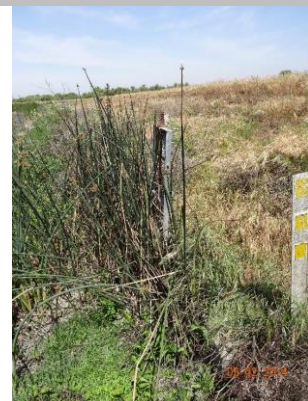
Photo 2 of 3 : UCIP_FA_2020_62012_66235.jpg

Slide gate visible on landward side blocked by vegetation.

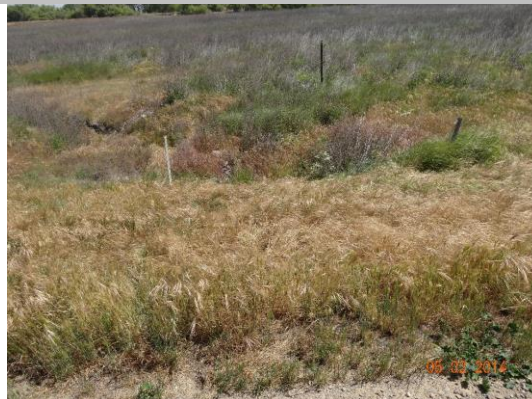
Photo 3 of 3 : UCIP_FA_2020_62012_66238.jpg

View of waterward side.

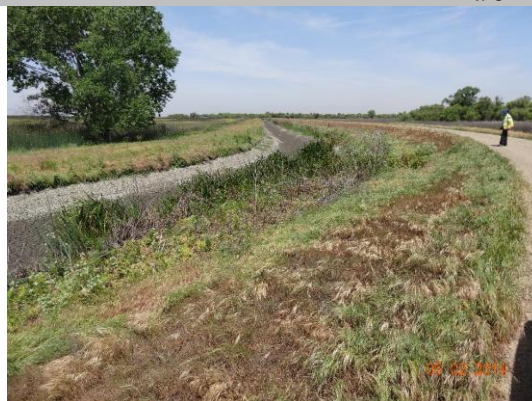
Photo 1 of 3 : UCIP_FA_2020_62016_66241.jpg

DS_ID:19690
 FS_ID:62016
 EP_NO: N/A
 Repair Type: Non-Urgent
 EVAL Issue:
 Crossing Status: Found
 UCIP Comments: 05/14/2014 Dense vegetation limits the inspector's visibility to identify signs of pipe failure (leaks) along the slope. Recommend removing vegetation along pipe alignment to conduct proper inspection of structure. (O. Magana - DWR UCIP)
 FIELD_STRUCT_DESC: 24-inch corrugated metal gravity drainage pipe through the levee, 8 feet below the crown. Flap gate on the waterside (WS) end. Screw gate on the landside (LS). [Additional Reference(s): DWR Levee Log, 2002 (HLM 11.45), listed as a 24-inch corrugated metal pipe (CMP). USACE San Joaquin O&M Manual, Unit 601 Part 1 (SJR 601.1), 1967, Revised 25 May 2011, (HLM 11.43), listed as a 24-inch CMP].
 FS Date: 5/14/2014

View of landward side.

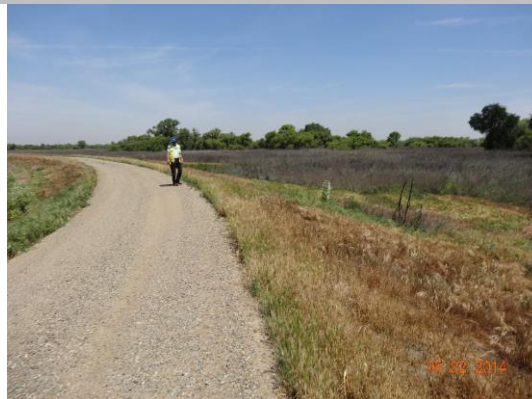
Photo 2 of 3 : UCIP_FA_2020_62016_66240.jpg

View of waterward side.

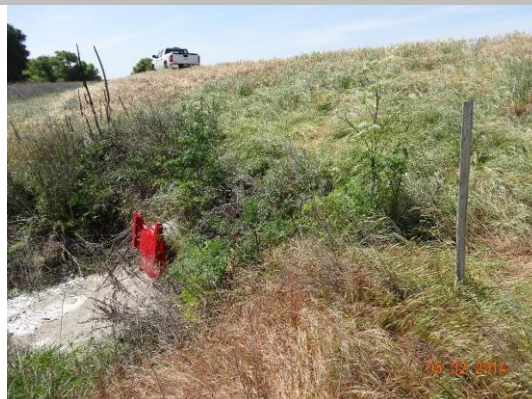
Photo 3 of 3 : UCIP_FA_2020_62016_66239.jpg

Flap gate visible on waterward toe.

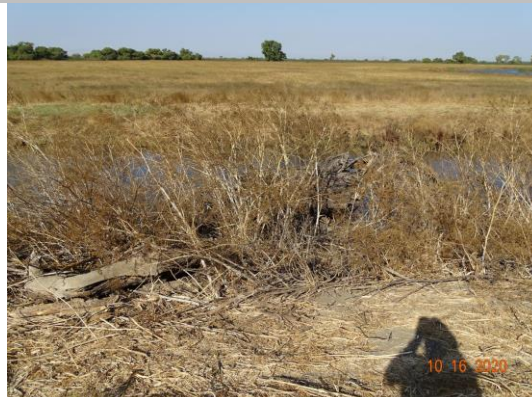
Photo 1 of 1 : FA_2020_NA0010_120_1_20201022_00043.jpg

| Fallen tree limbs are located on the landside slope. | | | | | |

Fallen tree on the landside slope. (Fall 2020)

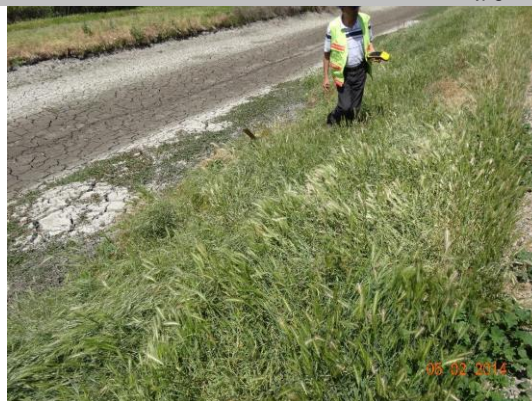
Photo 1 of 3 : UCIP_FA_2020_62018_66245.jpg

DS_ID:19663
FS_ID:62018
EP_NO: N/A
Repair Type: Non-Urgent
EVAL Issue:
Crossing Status: Found
UCIP Comments: 05/14/2014 Dense vegetation limits the inspector's visibility to identify signs of pipe failure (leaks) along the slope. Recommend removing vegetation along pipe alignment to conduct proper inspection of structure. Sediment buildup in pipe--recommend clearing. (O. Magana - DWR UCIP)
FIELD_STRUCT_DESC: 24-inch corrugated metal gravity drainage pipe through the levee, 6.5 feet below the crown. Slide gate in a pipe riser on the waterside (WS) slope. [Additional Reference(s): DWR Levee Log, 2002 (HLM 13.23), listed as a 24-inch corrugated metal pipe (CMP). USACE San Joaquin O&M Manual, Unit 601 Part 1 (SJR 601.1), 1967, Revised 25 May 2011, (recorded as HLM 13.32 should be HLM 13.22), listed as a 24-inch CMP].
FS Date: 5/14/2014

View of landward side.

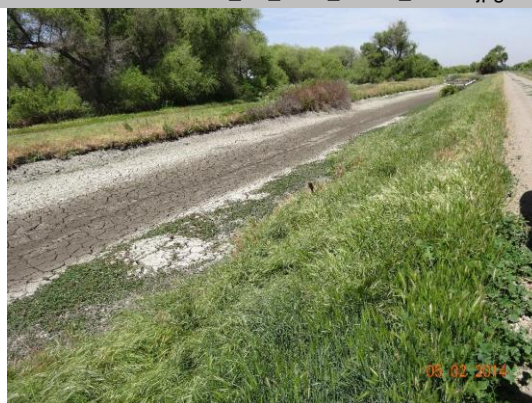
Photo 2 of 3 : UCIP_FA_2020_62018_66244.jpg

Overview of landward slope.

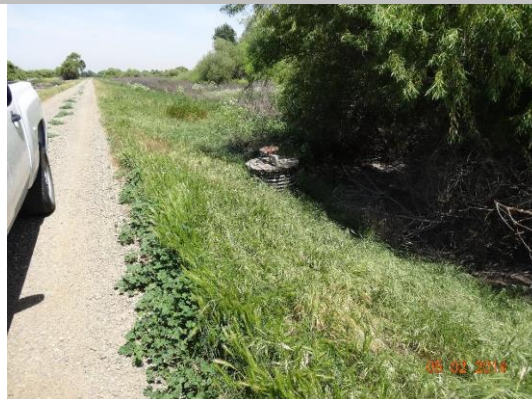
Photo 3 of 3 : UCIP_FA_2020_62018_66243.jpg

View of waterward side.

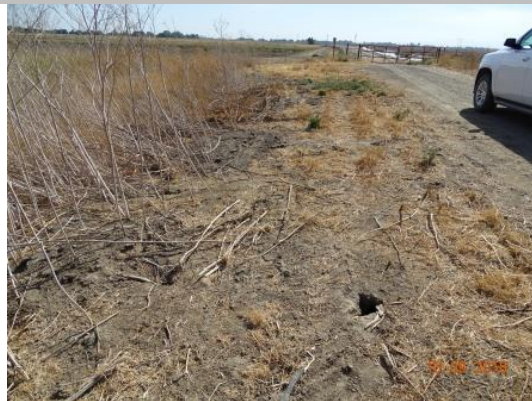
Photo 1 of 1 : FA_2020_NA0010_120_22_20200901_00005.jpg

| There are several rodent burrows observed at this location. | | | | | |

View of waterside slope looking upstream. (Fall 2018)
