Flood Control Project Maintenance Levee Inspections

Fall 2020 Levee Maintenance Deficiency Summary Report

San Joaquin River Basin

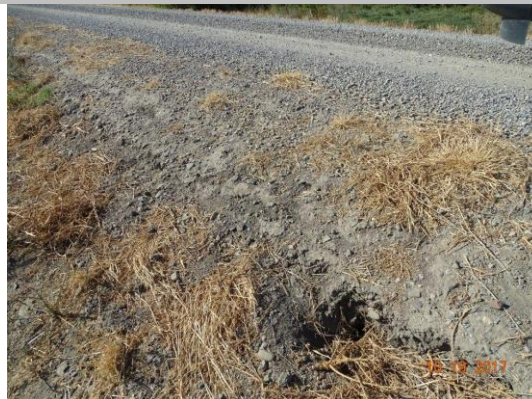
Photo 1 of 1 : FA_2020_NA0010_121_67_20200901_00004.jpg

| Rodent holes are noted on the landside slope. | | | | | |

Looking southwest at the landside shoulder.

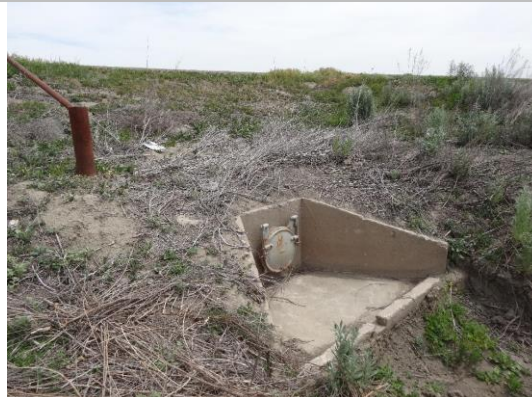
Photo 1 of 3 : UCIP_FA_2020_62020_61941.jpg

DS_ID:19691
FS_ID:62020
EP_NO: N/A
Repair Type: Non-Urgent
EVAL Issue:
Crossing Status: Found
UCIP Comments: 04/17/2014 Need to contact owner. Recommend removing tall grass on landward slope and clearing sediment build up inside pipe. (O. Magana - DWR UCIP)
FIELD_STRUCT_DESC: 24-inch corrugated metal gravity drainage pipe through the levee, 11.3 feet below the crown. Flap gate on the waterside (WS) end. [Additional Reference(s): DWR Levee Log, 2002 (HLM 0.43), listed as a 24-inch corrugated metal pipe (CMP). USACE San Joaquin O&M Manual, Unit 601 Part 1 (SJR 601.1), 1967, Revised 25 May 2011, (HLM 0.43), listed as a 24-inch CMP].
FS Date: 4/17/2014

Concrete structure and flap gate visible on waterward side.

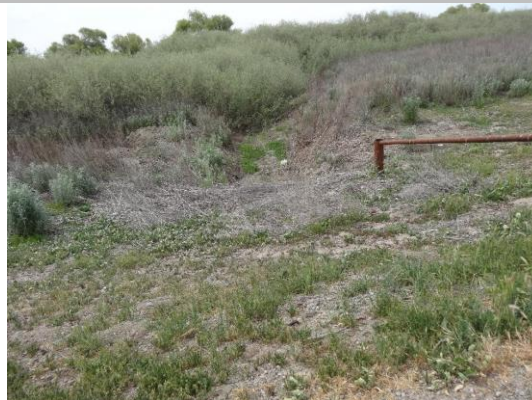
Photo 2 of 3 : UCIP_FA_2020_62020_61940.jpg

View of waterward side.

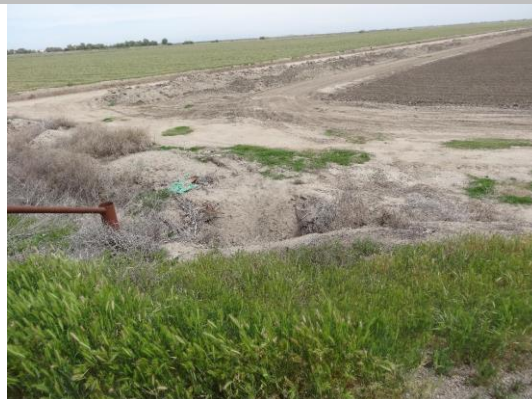
Photo 3 of 3 : UCIP_FA_2020_62020_61944.jpg

View of landward side.

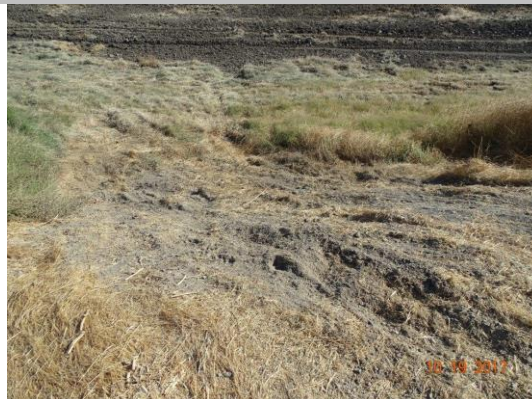
Photo 1 of 1 : FA_2020_NA0010_121_6_20200901_00002.jpg

Looking east at the landside slope.

| S3 : Repair the levee slope damaged by vehicle traffic and prevent access where possible. | | | | | |

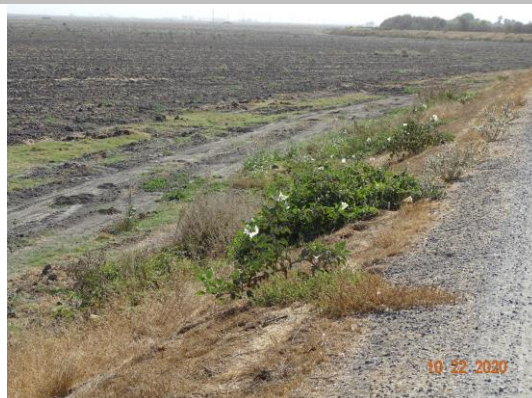
Photo 1 of 1 : FA_2020_NA0010_121_7_20201022_00017.jpg

View of the landside slope looking upstream. (Fall 2020)

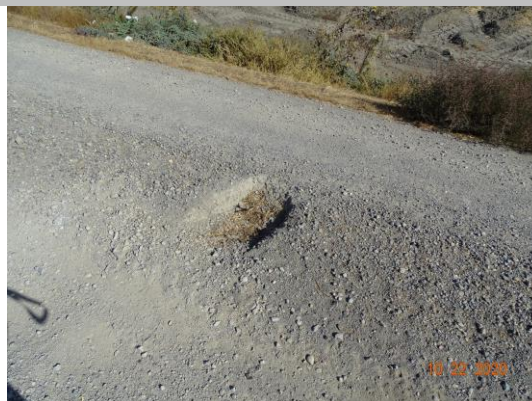
Photo 1 of 1 : FA_2020_NA0010_121_8_20201022_00018.jpg

Depression in the levee crown from rodent activity. (Fall 2020)

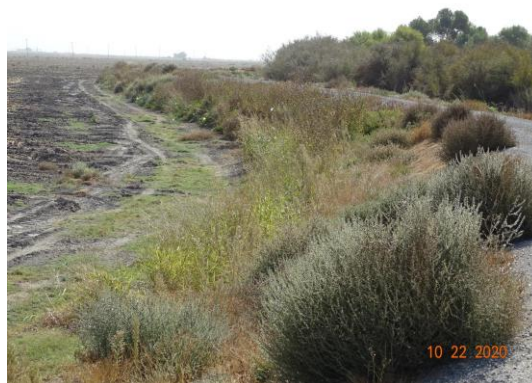
Photo 1 of 1 : FA_2020_NA0010_121_10_20201022_00019.jpg

Looking upstream along the landside slope. (Fall 2020)

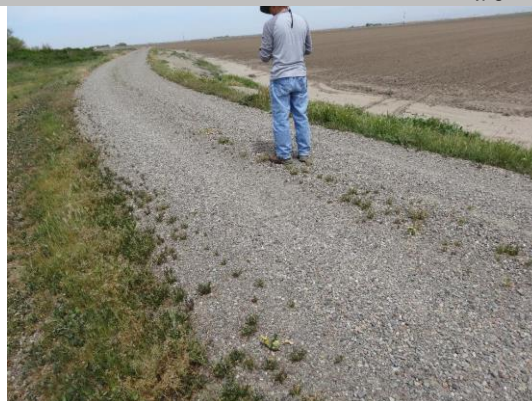
Photo 1 of 3 : UCIP_FA_2020_62023_66252.jpg

| UCIP Comments: 04/17/2014 Sediment buildup in pipe visible from landward side--recommend clearing. (O. Magana - DWR UCIP) | | | | | | |

View of levee crown at crossing.

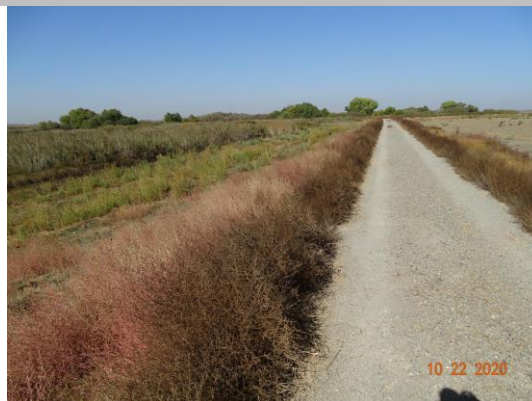
Photo 1 of 1 : FA_2020_NA0010_121_15_20201022_00020.jpg

Looking upstream along the waterside slope. (Fall 2020)

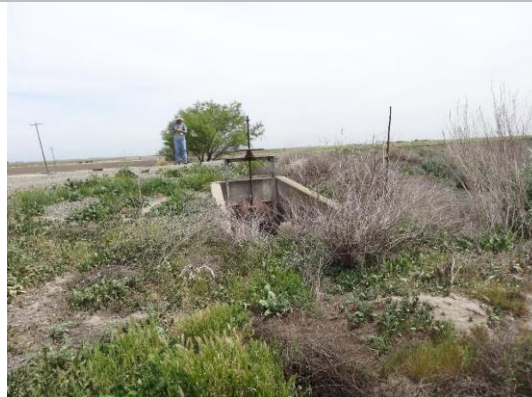
Photo 1 of 3 : UCIP_FA_2020_62024_66281.jpg

DS_ID:19694
FS_ID:62024
EP_NO: N/A
Repair Type: Non-Urgent
EVAL Issue:
Crossing Status: Found
UCIP Comments: 04/17/2014 Need to contact owner--additional appurtenances found on waterward side not part of original description. Unable to determine if walkway, pump, and pipe through waterward berm is if part of original crossing. (O. Magana - DWR UCIP)
FIELD_STRUCT_DESC: 36-inch corrugated metal irrigation discharge pipe through the levee, 6.6 feet below the crown. Pump on the riverbank. Slide gate on the waterside (WS) end. [Additional Reference(s): DWR Levee Log, 2002 (HLM 2.05), listed as a 36-inch corrugated metal pipe (CMP). USACE San Joaquin O&M Manual, Unit 601 Part 1 (SJR 601.1), 1967, Revised 25 May 2011, (HLM 2.05), listed as a 36-inch CMP].
FS Date: 4/17/2014

Slide gate and concrete structure located on waterward slope.

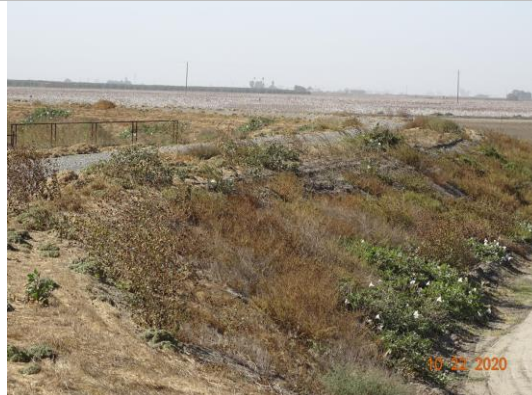
Photo 1 of 1 : FA_2020_NA0010_122_8_20201022_00020.jpg

View of vegetation on the landside slope. (Fall 2020)

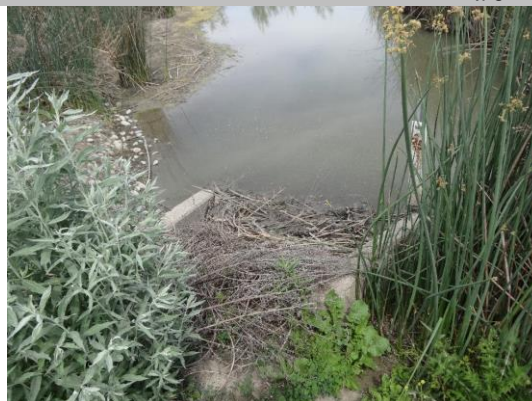
Photo 1 of 3 : UCIP_FA_2020_62029_61982.jpg

DS_ID:19695
FS_ID:62029
EP_NO: N/A
Repair Type: Non-Urgent
EVAL Issue:
Crossing Status: Found
UCIP Comments: 04/17/2014 Sediment and debris blocking concrete headwall located on waterward side. During inspection water was flowing from landward side to waterward side. Recommend removing sediment to confirm condition of flap gate and pipe. (O. Magana - DWR UCIP)
FIELD_STRUCT_DESC: 36-inch corrugated metal gravity drainage pipe through the levee, 18 feet below the crown. Flap gate on the waterside (WS) end. Concrete headwall on each end. [Additional Reference(s): DWR Levee Log, 2002[Additional Resource(s): DWR Levee Log, 2002 (HLM 0.03), listed as four 6-foot by 5-foot concrete culverts] (HLM 0.24), listed as a 36-inch corrugated metal pipe (CMP). USACE San Joaquin O&M Manual, Unit 601 Part 1 (SJR 601.1), 1967, Revised 25 May 2011, (HLM 0.27), listed as a 36-inch CMP].
FS Date: 4/17/2014

View of dense vegetation near concrete headwall located on waterward side.

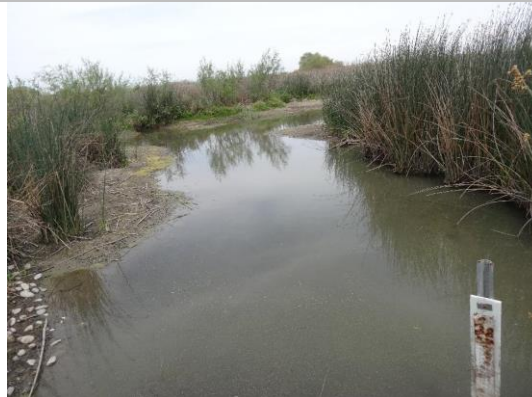
Photo 3 of 3 : UCIP_FA_2020_62029_61980.jpg

View of waterward side.

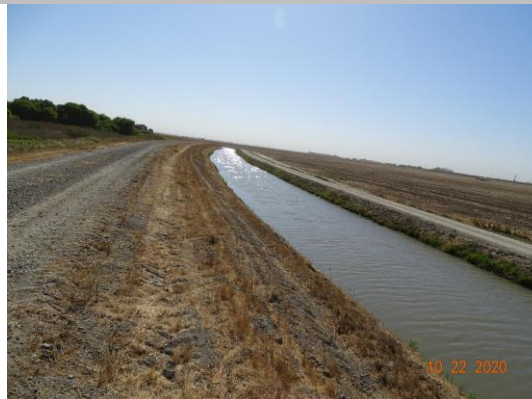
Photo 1 of 1 : FA_2020_NA0010_122_3_20201022_00021.jpg

| An irrigation ditch is within 10' easement. | | | | | |

Looking upstream at an irrigation ditch at the landside toe. (Fall 2020)

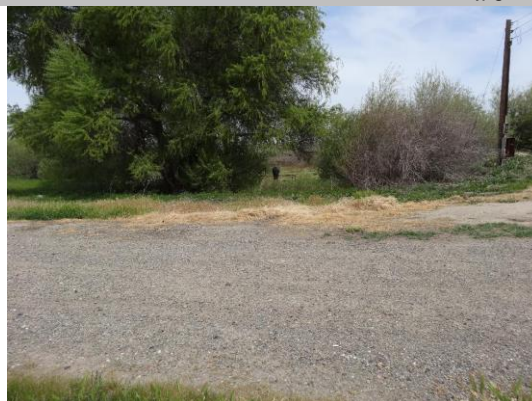
Photo 1 of 3 : UCIP_FA_2020_40530_61987.jpg

| DS_ID:19975 FS_ID:40530 EP_NO: 3416 Repair Type: Non-Urgent EVAL Issue: Crossing Status: Found UCIP Comments: Unable to confirm if crossing is still in use. Need to contact owner to confirm status. FIELD_STRUCT_DESC: 12-inch steel irrigation pipe, encased in 6-inches of reinforced concrete through the levee. Concrete cutoff wall at center of levee. Pumping plant on the waterward bank. Pump and irrigation pipe retained under Permit No. 3416 (1964). FS Date: 4/17/2014 | | | | | |

View of waterward side.

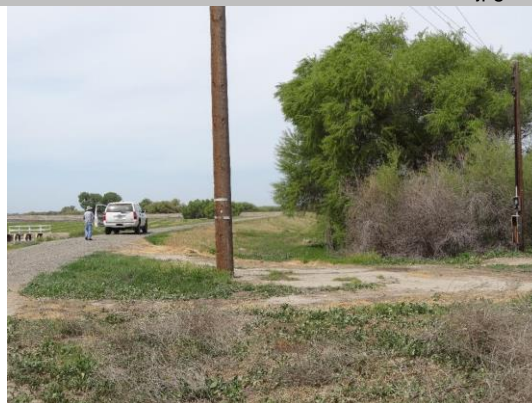
Photo 2 of 3 : UCIP_FA_2020_40530_61988.jpg

Overview of waterward side and levee crown at crossing.

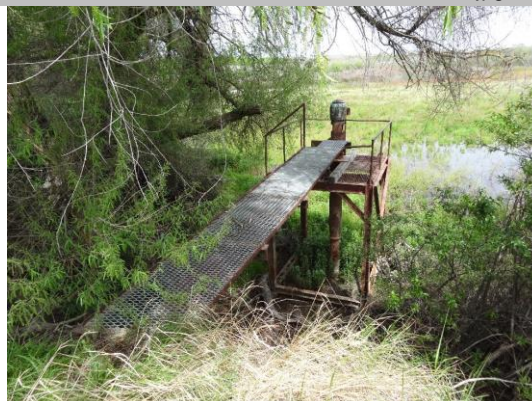
Photo 3 of 3 : UCIP_FA_2020_40530_61986.jpg

Pump and walkway located on waterward side.

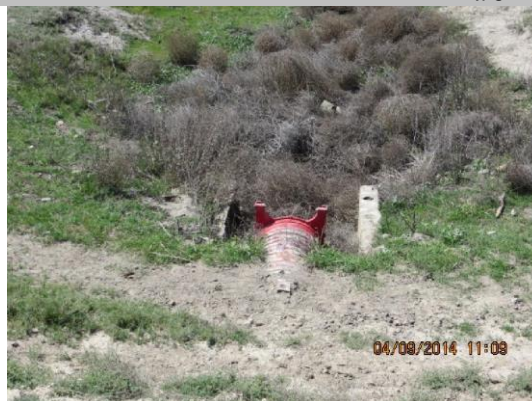
Photo 1 of 3 : UCIP_FA_2020_62422_60921.jpg

| DS_ID:19756 FS_ID:62422 EP_NO: N/A Repair Type: Non-Urgent EVAL Issue: Crossing Status: Found UCIP Comments: 04/09/2014 Debris blocking landward headwall--recommend clearing. (W. Wylie - DWR UCIP) FIELD_STRUCT_DESC: 24-inch corrugated metal gravity drainage pipe through the levee, 8.6 feet below the crown. Concrete U-shaped headwall and flap gate on the waterside (WS) end. Concrete headwall on the landside (LS) end. [Additional Reference(s): DWR Levee Log, 2002 (HLM 0.07), listed as a 24-inch corrugated metal pipe [CMP]. USACE San Joaquin O&M Manual, Unit 601 Part 1 (SJR601.1), 1967, Revised 25 May 2011, (HLM 0.07), listed as a 24-inch CMP] FS Date: 4/9/2014 | | | | | |

Pipe, flapgate, and concrete headwall on WS toe.

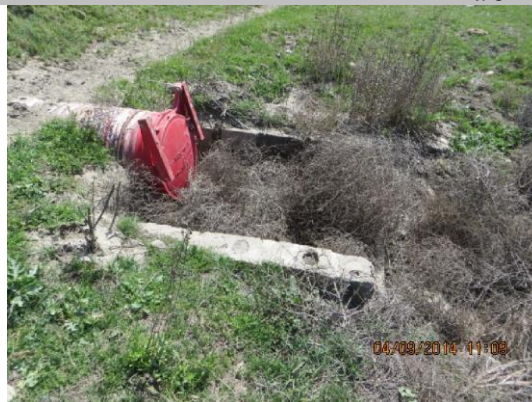
Photo 2 of 3 : UCIP_FA_2020_62422_60920.jpg

Pipe, flapgate, and concrete headwall on WS toe.

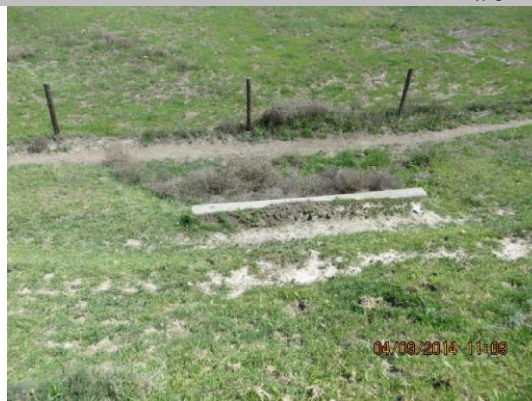
Photo 3 of 3 : UCIP_FA_2020_62422_60922.jpg

Pipe and concrete headwall on LS toe.

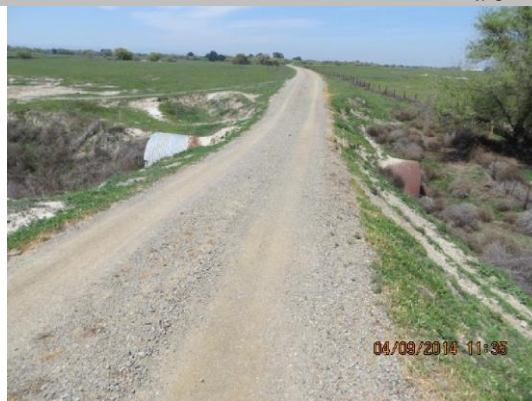
Photo 1 of 3 : UCIP_FA_2020_62420_71469.jpg

DS_ID:24867
 FS_ID:62420
 EP_NO: N/A
 Repair Type: Urgent
 EVAL Issue:
 Crossing Status: Found
 UCIP Comments: 11/01/2018 Same as previous inspection, 1960s levee breach; degraded levee section that drops about 4 feet within a 100-foot levee section. Crossing remains Urgent due to the levee degradation at this location. (O. Magana - DWR UCIP)07/20/2016 same as previous inspection. Levee section at crossing has been degraded. According to LMA representative, Rick, the low point at crossing has been present for over 10 years when the pipe was replaced. (O. Magana - DWR UCIP)04/09/2014 Pipe is open on both ends and levee has been degraded at this location. No permit identified for this crossing. (W. Wylie - DWR UCIP)
 FIELD_STRUCT_DESC: 96-inch corrugated metal gravity drainage pipe through the levee, 4.5 feet below the crown. Pipe is composed of two materials: corrugated metal pipe (CMP) on the waterside (WS) and steel pipe on the landside (LS). This section of the levee is a degraded section that drops approximately 4 feet within 100 feet of length. This section of the levee is the site of the 1960s levee breach. [Additional Reference(s): USACE Periodic Inspection Report 2014, USACE_CESPK_L05A_2014_p_0014].

Pipe through levee where levee has been degraded.

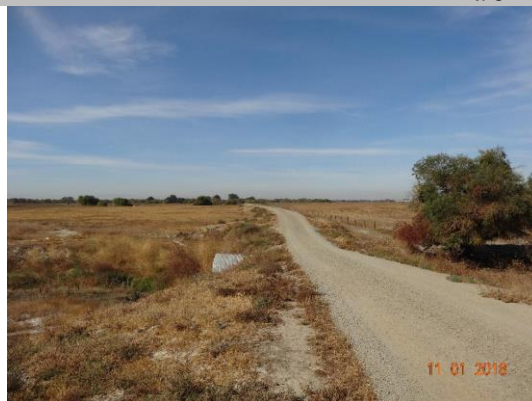
Photo 1 of 3 : UCIP_FA_2020_62423_78592.jpg

| DS_ID:19557 FS_ID:62423 EP_NO: N/A Repair Type: Non-Urgent EVAL Issue: Crossing Status: Indicator Found UCIP Comments: 11/01/2018 24-inch corrugated metal pipe (CMP) section found during pipe inspection of dsid 24867 (see photos); according to LMA representative levee section is the location of levee breach from 1960s; 24-inch pipe was undersized and was replaced after levee breach with a 96-inch CMP and steel pipe. (O. Magana - DWR UCIP) FIELD_STRUCT_DESC: 24-inch corrugated metal gravity drainage pipe through the levee, 5.6 feet below the crown. Flap gate on the waterside (WS) end. Large pipe found at this location. [Additional Reference(s): USACE San Joaquin O&M Manual, Unit 601 Part 1 (SJR601.1), 1967, Revised 25 May 2011, (HLM 0.30), listed as a 24-inch corrugated metal pipe (CMP)] FS Date: 4/9/2014 | | | | | | |

Overview of degraded levee section.

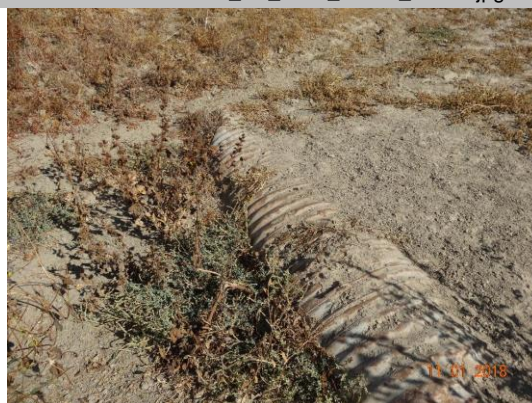
Photo 2 of 3 : UCIP_FA_2020_62423_78593.jpg

LS view: CMP section found on LS.

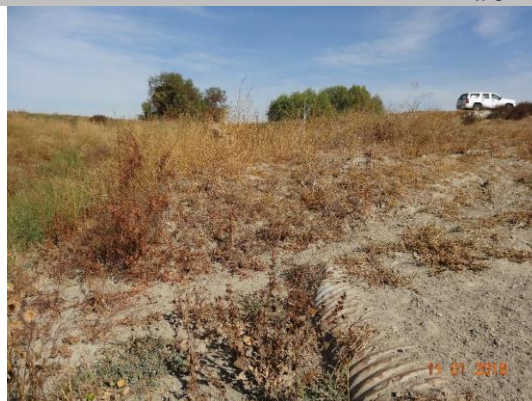
Photo 3 of 3 : UCIP_FA_2020_62423_78594.jpg

LS view: 24-inch pipe section found west of LS toe.

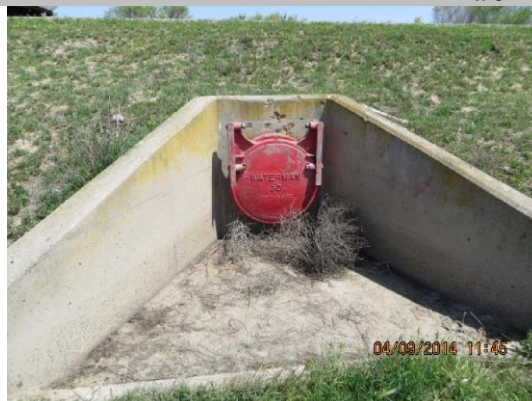
Photo 2 of 3 : UCIP_FA_2020_62424_60925.jpg

Concrete headwall, pipe, and flapgate on WS toe.

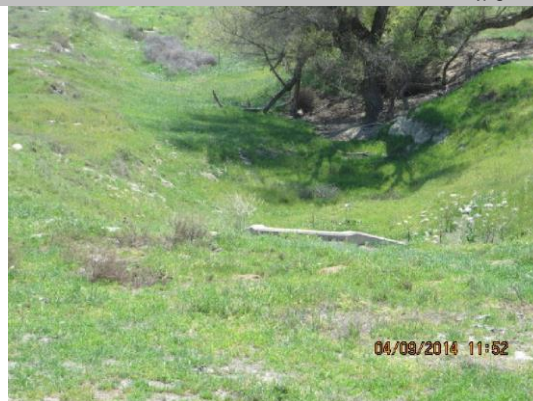
Photo 1 of 3 : UCIP_FA_2020_62519_60931.jpg

DS_ID:19758
FS_ID:62519
EP_NO: N/A
Repair Type: Non-Urgent
EVAL Issue:
Crossing Status: Found
UCIP Comments: 04/09/2014 Dense vegetation limits the inspector's visibility to identify signs of pipe failure (leaks) along the landward slope. Recommend removing vegetation along pipe alignment to conduct proper inspection of structure. (W. Wylie - DWR UCIP)
FIELD_STRUCT_DESC: 36-inch corrugated metal gravity drainage pipe through the levee, 13.2 feet below the crown. Flap gate on the waterside (WS) end. Concrete headwall on the landside (LS) end. Concrete U-shaped headwall on the WS end. Cobble revetment around both ends. [Additional Reference(s): DWR Levee Log, 2002 (HLM 0.64), listed as a 36-inch corrugated metal pipe (CMP). USACE San Joaquin O&M Manual, Unit 601 Part 1 (SJR601.1), 1967, Revised 25 May 2011, (HLM 0.65), listed as a 36-inch CMP].
FS Date: 4/9/2014

Concrete headwall visible off WS toe.

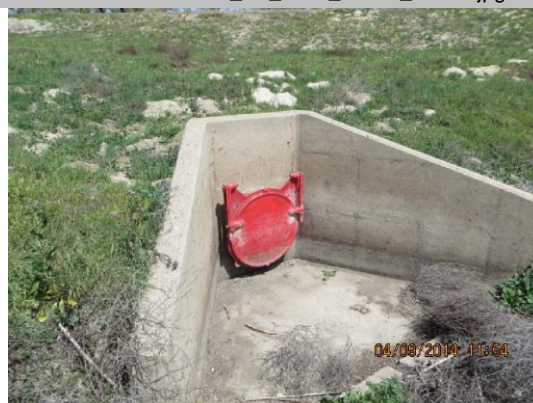
Photo 2 of 3 : UCIP_FA_2020_62519_60929.jpg

Pipe, flapgate, and headwall at WS toe.

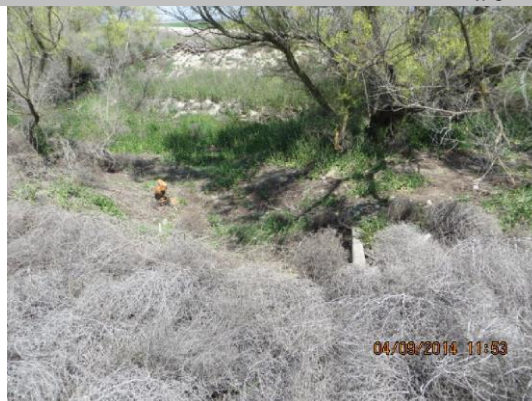
Photo 3 of 3 : UCIP_FA_2020_62519_60930.jpg

Concrete headwall at LS toe.

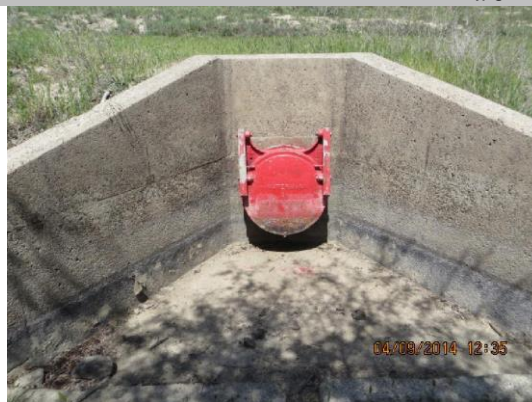
Photo 2 of 3 : UCIP_FA_2020_62427_60941.jpg

Headwall, pipe, and flapgate on WS toe.

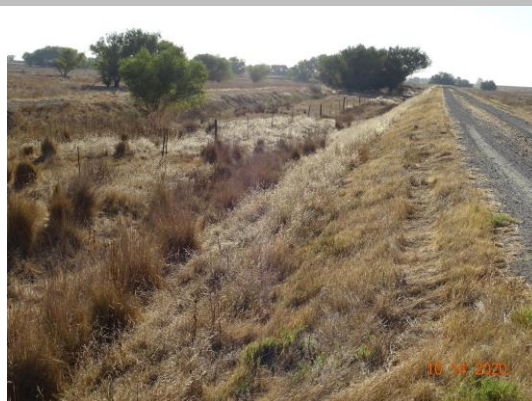
Photo 1 of 1 : FA_2020_NA0010_123_100_20201028_00305.jpg

View of vegetation on the landside slope. (Fall 2020)

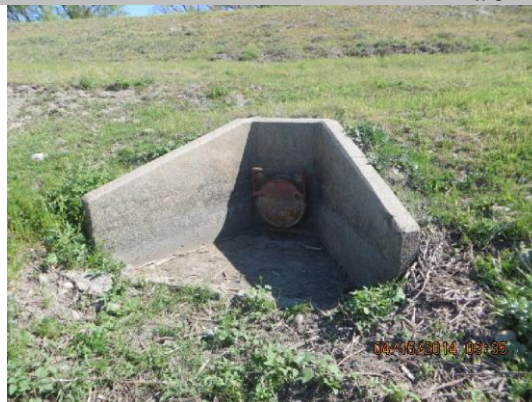
Photo 2 of 3 : UCIP_FA_2020_62421_60946.jpg

Flapgate and Concrete headwall at WS toe.

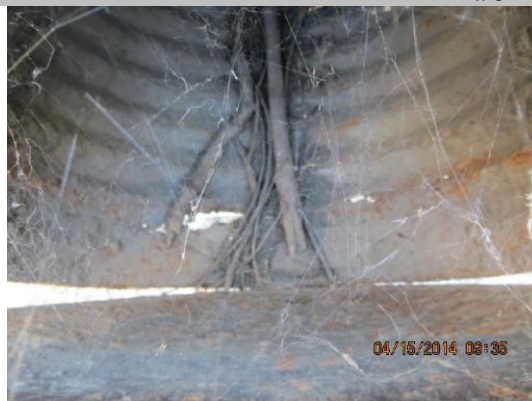
Photo 3 of 3 : UCIP_FA_2020_62421_60951.jpg

| UCIP Comments: 04/15/2014 Pipe corroded through at flapgate on WS toe. (W. Wylie - DWR UCIP) | | | | | |

Pipe corroded through just behind flapgate at WS toe.

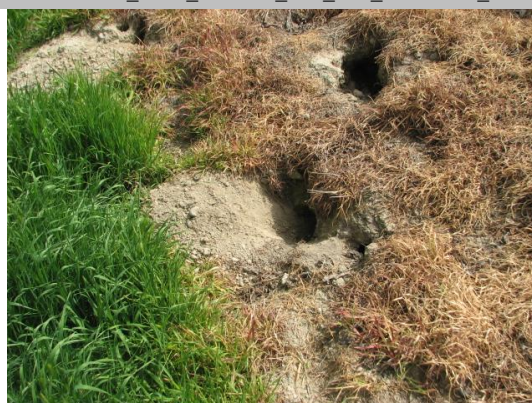
Photo 1 of 1 : FA_2020_NA0010_123_134_20200901_00016.jpg

| Several rodent holes are located within this section. | | | | | |

Looking at typical rodent holes within this section. (Spring 2018)

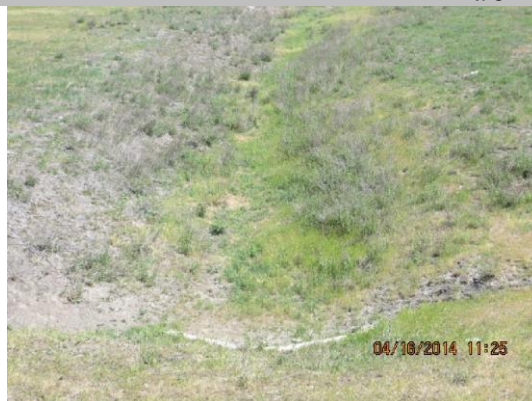
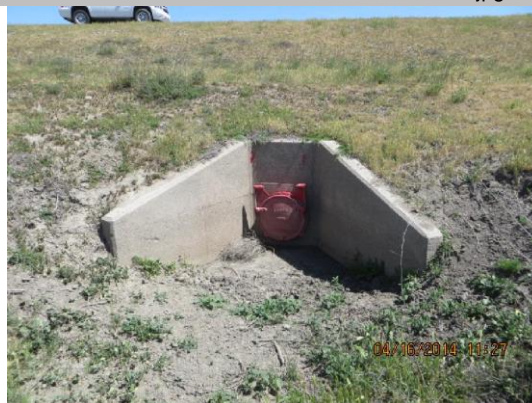
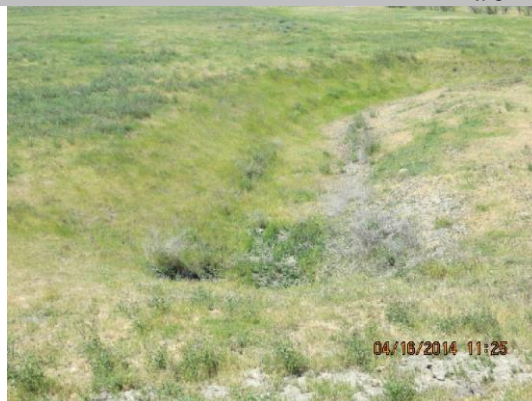
DS_ID:19811
 FS_ID:62430
 EP_NO: N/A
 Repair Type: Non-Urgent
 EVAL Issue:
 Crossing Status: Found
 UCIP Comments: 04/16/2014 Sediment buildup in pipe visible from landward side--recommend contacting owner to clear pipe. (W. Wylie - DWR UCIP)
 FIELD_STRUCT_DESC: 24-inch corrugated metal gravity drainage pipe through the levee, 15 feet below the crown. Flap gate on the waterside (WS) end. Concrete headwall on the landside (LS) end. Concrete U-shaped headwall on the WS end. [Additional Reference(s): DWR Levee Log, 2002 (HLM 3.67), listed as a 24-inch corrugated metal pipe (CMP). USACE San Joaquin O&M Manual, Unit 601 Part 1 (SJR601.1), 1967, Revised 25 May 2011, (HLM 3.67), listed as a 24-inch CMP]
 FS Date: 4/16/2014

Pipe, headwall, and flapgate on WS toe.

Pipe and headwall on LS toe.

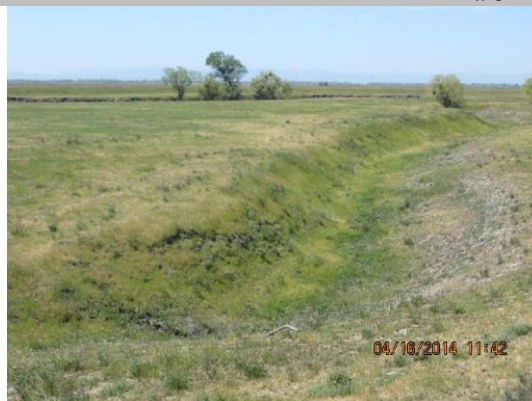
DS_ID:19769
 FS_ID:62431
 EP_NO: N/A
 Repair Type: Non-Urgent
 EVAL Issue:
 Crossing Status: Found
 UCIP Comments: 04/16/2014 Sediment buildup in pipe visible from landward side--recommend contacting owner to clear pipe. (W. Wylie - DWR UCIP)
 FIELD_STRUCT_DESC: 24-inch corrugated metal gravity drainage pipe through the levee, 16 feet below the crown. Flap gate on the waterside (WS) end. Concrete U-shaped headwall on each end.
 [Additional Reference(s): DWR Levee Log, 2002 (HLM 4.01), listed as a 24-inch corrugated metal pipe (CMP). USACE San Joaquin O&M Manual, Unit 601 Part 1 (SJR601.1), 1967, Revised 25 May 2011, (HLM 4.02), listed as a 24-inch CMP]
 FS Date: 4/16/2014

Pipe, headwall, and flapgate on WS toe.

Pipe and headwall on LS toe.

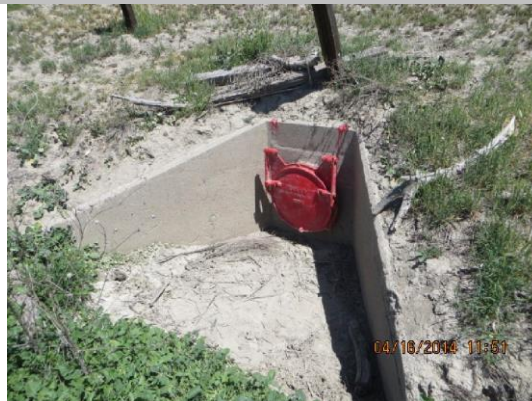
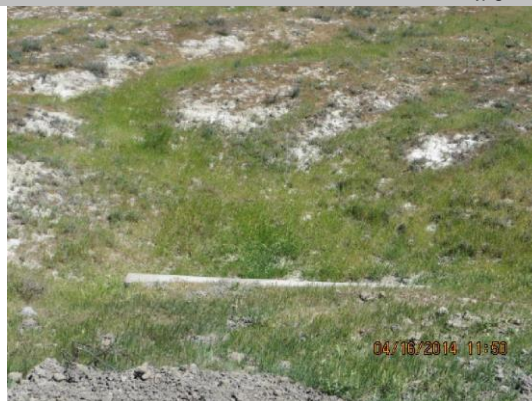
| DS_ID:19770 FS_ID:62432 EP_NO: N/A Repair Type: Non-Urgent EVAL Issue: Crossing Status: Found UCIP Comments: 04/16/2014 Sediment buildup in pipe visible from landward side--recommend contacting owner to clear pipe. (W. Wylie - DWR UCIP) FIELD_STRUCT_DESC: 24-inch corrugated metal gravity drainage pipe through the levee, 11.6 feet below the crown. Flap gate on the waterside (WS) end. Concrete headwall on the landside (LS) end. Concrete U-shaped headwall on the WS end. [Additional Reference(s): DWR Levee Log, 2002 (HLM 4.27), listed as a 24-inch corrugated metal pipe (CMP). USACE San Joaquin O&M Manual, Unit 601 Part 1 (SJR601.1), 1967, Revised 25 May 2011, (HLM 4.27), listed as a 24-inch CMP] FS Date: 4/16/2014 | | | | | |

Pipe, headwall, and flapgate on WS toe.

Concrete headwall and pipe on LS toe.

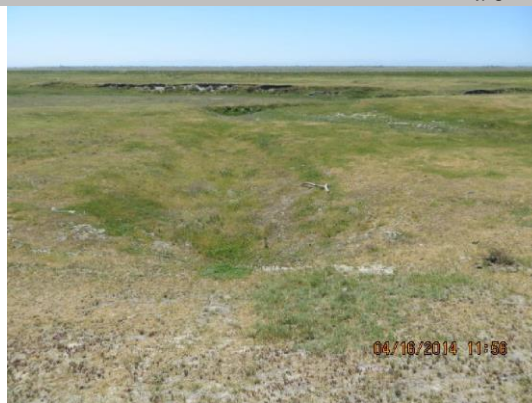
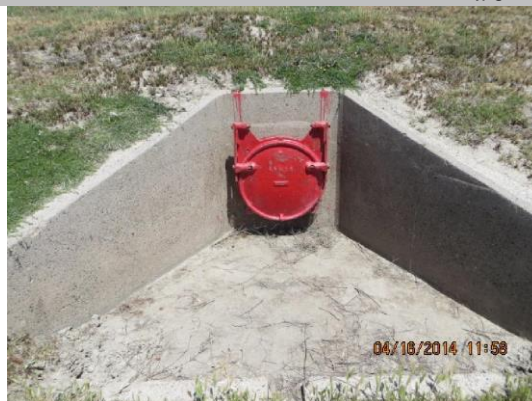
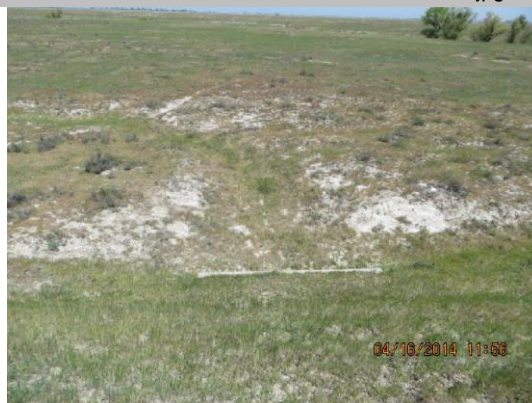
| DS_ID:19771 FS_ID:62433 EP_NO: N/A Repair Type: Non-Urgent EVAL Issue: Crossing Status: Found UCIP Comments: 04/16/2014 Sediment buildup in pipe visible from landward side--recommend contacting owner to clear pipe. (W. Wylie - DWR UCIP) FIELD_STRUCT_DESC: 24-inch corrugated metal gravity drainage pipe through the levee, 12 feet below the crown. Flap gate on the waterside (WS) end. Concrete headwall on the landside (LS) end. Concrete U-shaped headwall on the WS end. [Additional Reference(s): DWR Levee Log, 2002 (HLM 4.53), listed as a 24-inch corrugated metal pipe (CMP). USACE San Joaquin O&M Manual, Unit 601 Part 1 (SJR601.1), 1967, Revised 25 May 2011, (HLM 4.54), listed as a 24-inch CMP] FS Date: 4/16/2014 8:16:00 AM | | | | | | |

Pipe, flapgate, and headwall on WS toe.

Pipe and headwall on LS toe.

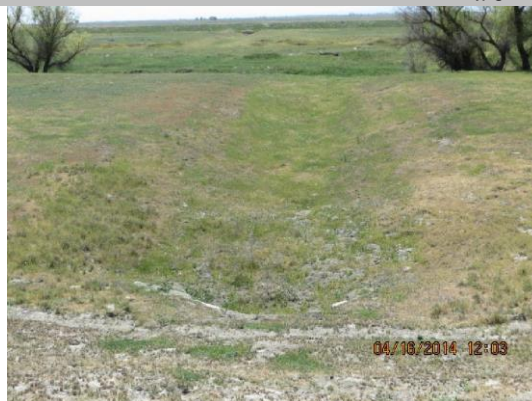
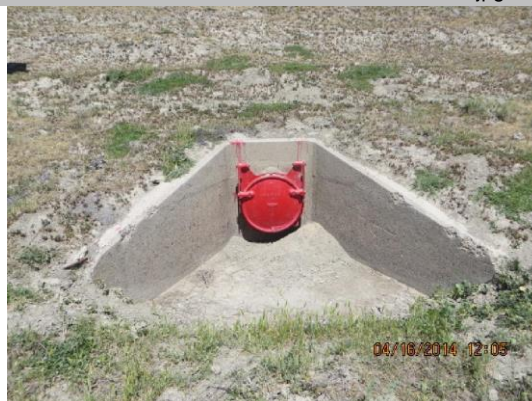
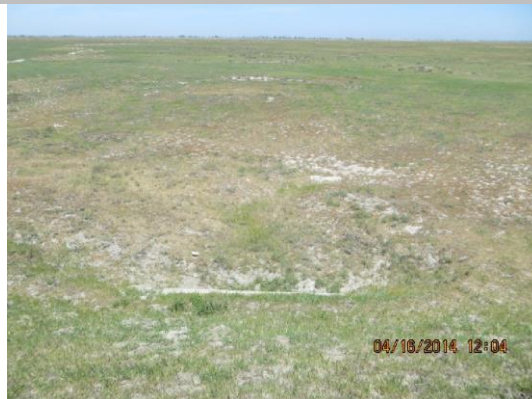
| DS_ID:19772 FS_ID:62434 EP_NO: N/A Repair Type: Non-Urgent EVAL Issue: Crossing Status: Found UCIP Comments: 04/16/2014 Heavy sediment buildup in pipe visible from landward side--recommend contacting owner to clear pipe. (W. Wylie - DWR UCIP) FIELD_STRUCT_DESC: 24-inch corrugated metal gravity drainage pipe through the levee, 12.3 feet below the crown. Flap gate on the waterside (WS) end. Concrete headwall on the landside (LS) end. Concrete U-shaped headwall on the WS end. [Additional Reference(s): DWR Levee Log, 2002 (HLM 4.89), listed as a 24-inch corrugated metal pipe (CMP). USACE San Joaquin O&M Manual, Unit 601 Part 1 (SJR601.1), 1967, Revised 25 May 2011, (HLM 4.89), listed as a 24-inch CMP] FS Date: 4/16/2014 | | | | | |

Headwall, flapgate, and pipe on WS toe.

Headwall and pipe on LS toe.

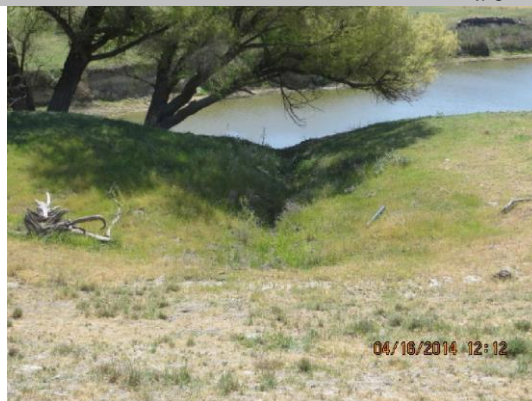
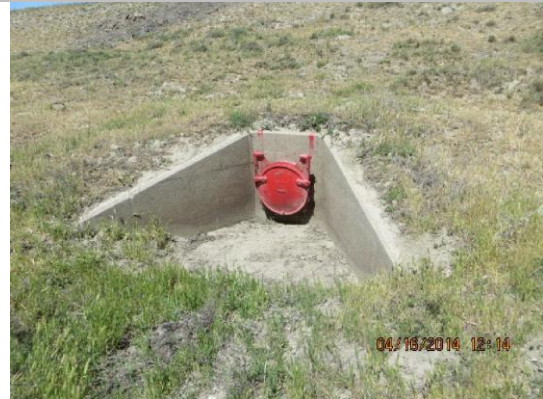
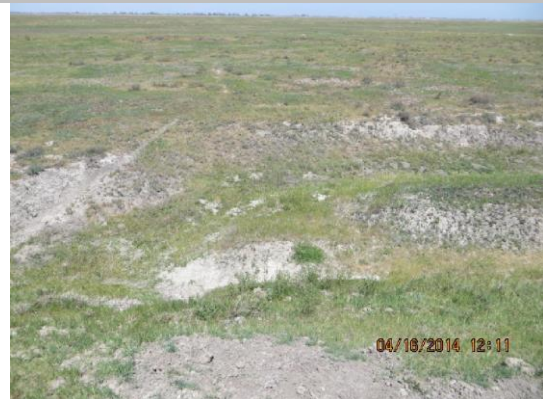
DS_ID:19773
 FS_ID:62435
 EP_NO: N/A
 Repair Type: Non-Urgent
 EVAL Issue:
 Crossing Status: Found
 UCIP Comments: 04/16/2014 Heavy sediment buildup in pipe visible from landward side--recommend contacting owner to clear pipe. (W. Wylie - DWR UCIP)
 FIELD_STRUCT_DESC: 24-inch corrugated metal gravity drainage pipe through the levee, 12.2 feet below the crown. Flap gate on the waterside (WS) end. Concrete headwall on the landside (LS) end. Concrete U-shaped headwall on the WS end. [Additional Reference(s): DWR Levee Log, 2002 (HLM 5.14), listed as a 24-inch corrugated metal pipe (CMP). USACE San Joaquin O&M Manual, Unit 601 Part 1 (SJR601.1), 1967, Revised 25 May 2011, (HLM 5.15), listed as a 24-inch CMP]
 FS Date: 4/16/2014

Headwall, flapgate, and pipe on WS toe.

Headwall and pipe on LS toe.

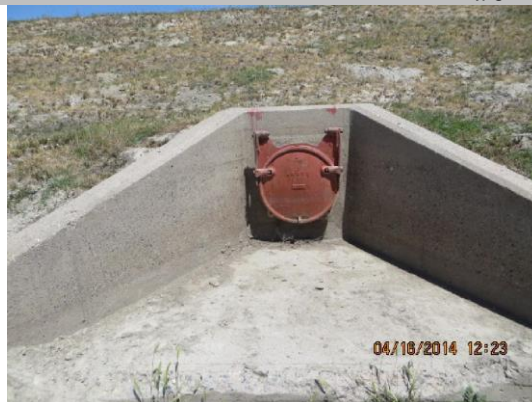
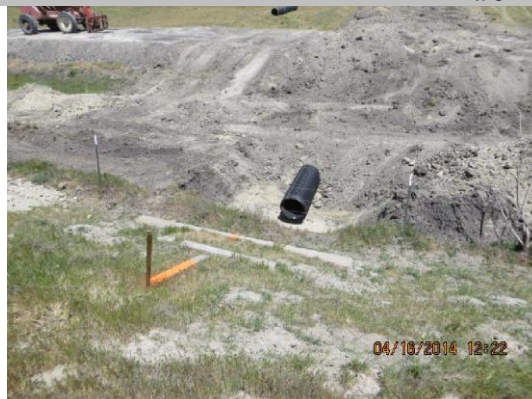
Headwall, flapgate, and pipe on WS toe.

Headwall and pipe on LS toe with HDPE drain pipe being installed off LS toe.

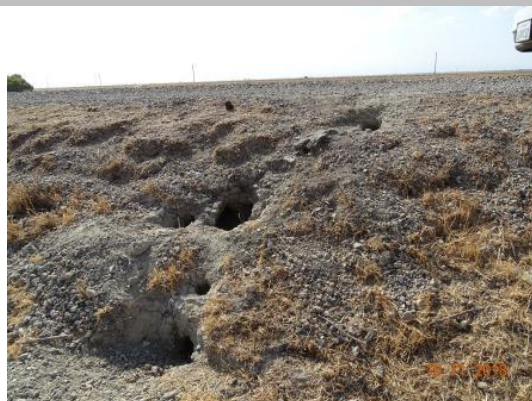
Photo 1 of 1 : FA_2020_NA0010_123_138_20200901_00017.jpg

| Several large rodent holes are located at this location. | | | | | |

View of large rodent holes in landside slope. (Fall 2018)

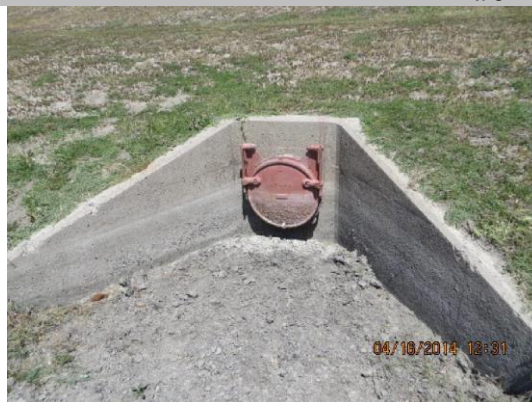
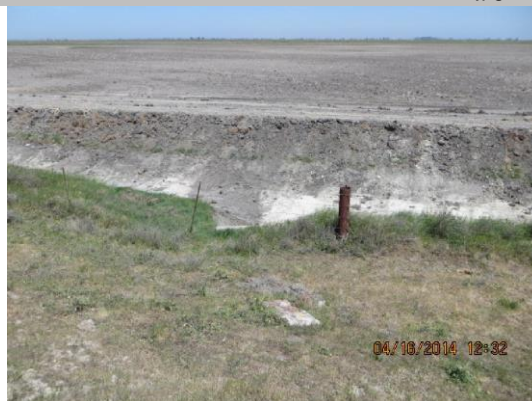
Headwall, flapgate, and pipe on WS toe.

Headwall and pipe on LS toe.

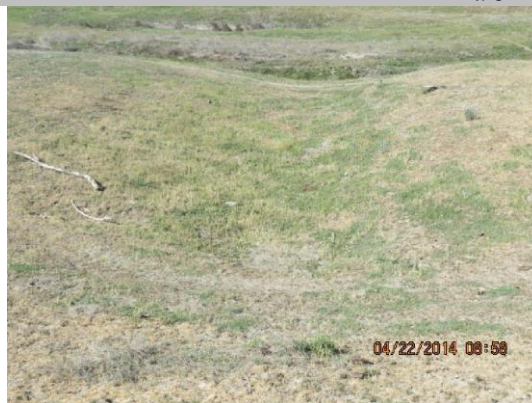
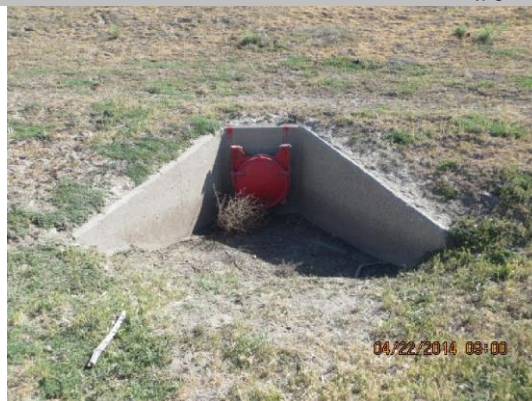
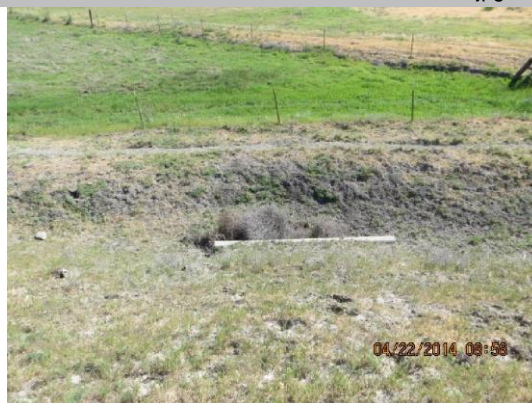
| DS_ID:19761 FS_ID:62428 EP_NO: N/A Repair Type: Non-Urgent EVAL Issue: Crossing Status: Found UCIP Comments: 04/22/2014 Sediment buildup in pipe visible from landward side--recommend contacting owner to clear pipe. (W. Wylie - DWR UCIP) FIELD_STRUCT_DESC: 24-inch corrugated metal gravity drainage pipe through the levee, 12 feet below the crown. Flap gate on the waterside (WS) end. Concrete headwall on the landside (LS) end. Concrete U-shaped headwall on the waterside (WS) end. [Additional Reference(s): DWR Levee Log, 2002 (HLM 7.36), listed as a 24-inch corrugated metal pipe (CMP). USACE San Joaquin O&M Manual, Unit 601 Part 1 (SJR601.1), 1967, Revised 25 May 2011, (HLM 7.36), listed as a 24-inch CMP] FS Date: 4/22/2014 | | | | | | |

Headwall, flapgate, and pipe on WS toe.

Headwall and pipe on LS toe.

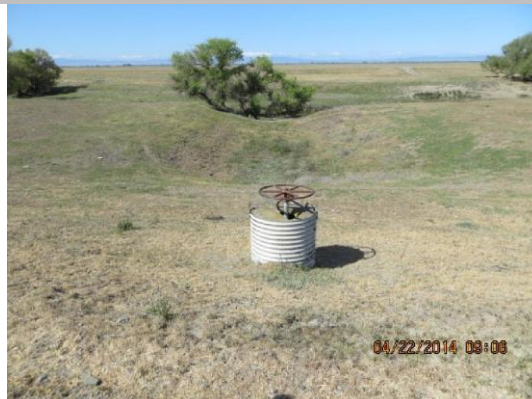
Photo 2 of 2 : UCIP_FA_2020_62429_62115.jpg

Slide gate in CMP riser on WS slope. No outlet or pipe found on WS toe.

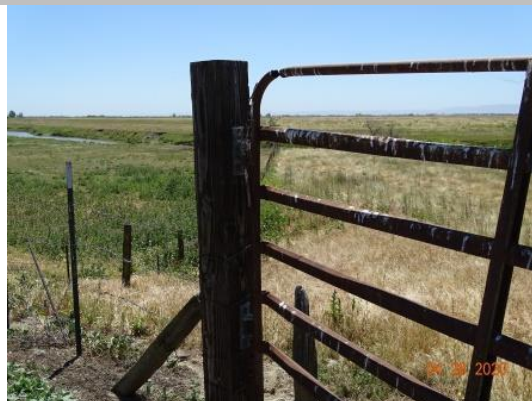
Photo 1 of 1 : FA_2020_NA0010_123_104_20200901_00007.jpg

| The gate is not opening correctly due to a bent fence post. | | | | | |

Gate is broken near the hinge. (Spring 2020)

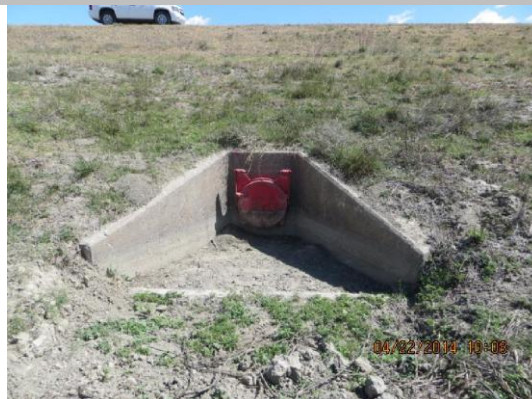
Photo 2 of 3 : UCIP_FA_2020_62451_62183.jpg

Headwall, flapgate, and pipe on WS toe

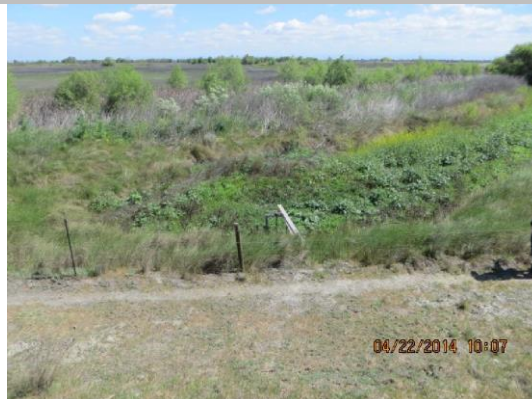
Photo 3 of 3 : UCIP_FA_2020_62451_62181.jpg

Headwall, slidegate, and pipe on LS toe.

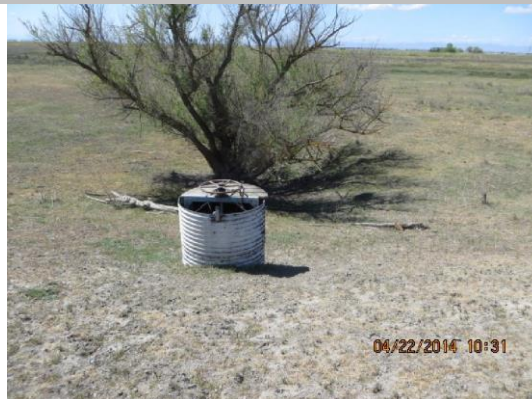
Photo 1 of 3 : UCIP_FA_2020_62455_62196.jpg

Slide gate in 48-inch CMP riser on WS slope.

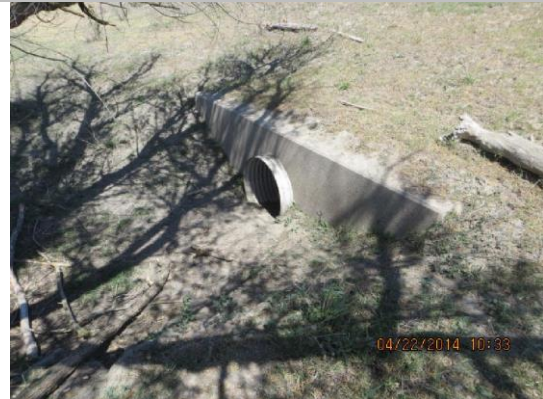
Photo 2 of 3 : UCIP_FA_2020_62455_62198.jpg

Headwall and pipe at WS toe.

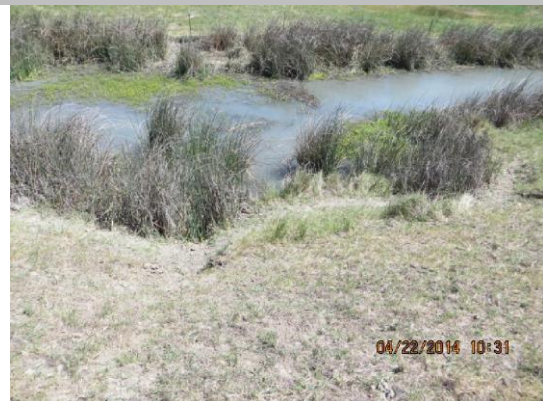
Photo 3 of 3 : UCIP_FA_2020_62455_62197.jpg

Headwall and pipe at LS toe.

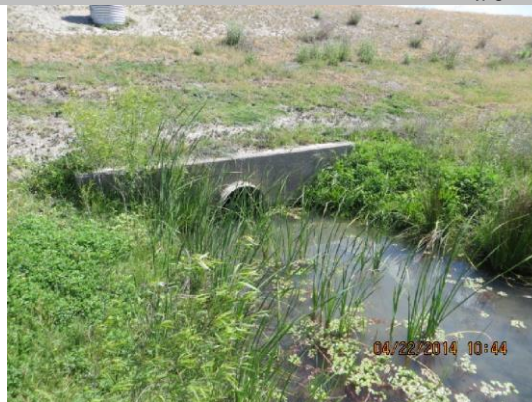
Photo 2 of 3 : UCIP_FA_2020_62456_62202.jpg

Concrete headwall and pipe on WS toe.

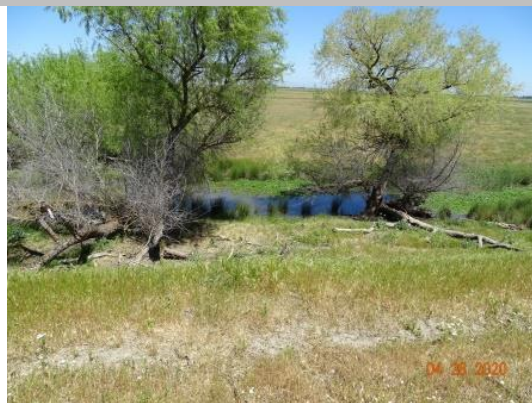
Photo 1 of 1 : FA_2020_NA0010_123_144_20200901_00021.jpg

View of tree limbs on levee slope. (Spring 2020)

| Tree limbs on the levee slope should be trimmed to allow access. | | | | | |

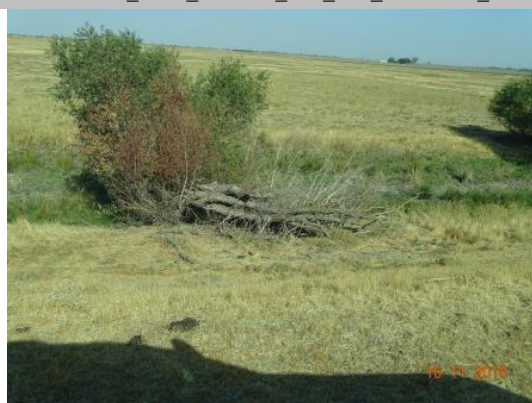
Photo 1 of 1 : FA_2020_NA0010_123_145_20200901_00022.jpg

| A fallen tree trunk is located on the levee toe. | | | | | |

Fallen tree on levee toe. (Fall 2018)

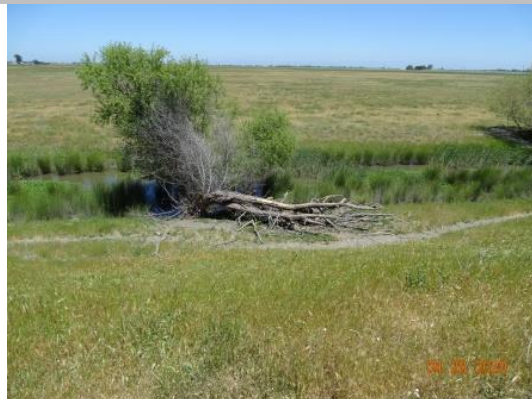
Photo 1 of 1 : FA_2020_NA0010_123_146_20200901_00023.jpg

| Fallen tree limbs are located on the levee toe. | | | | | |

Tree limbs and trunk on levee toe. (Spring 2020)

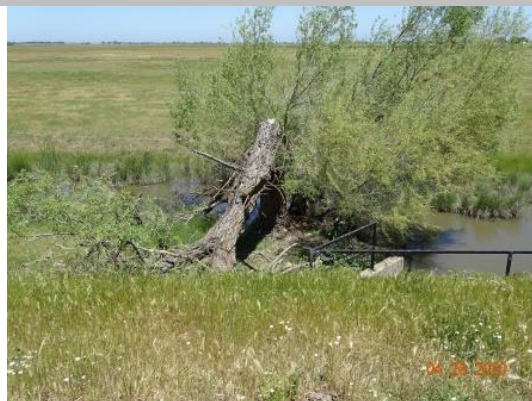
Photo 1 of 1 : FA_2020_NA0010_123_147_20200901_00024.jpg

| Tree limbs are located on landside slope and toe. | | | | | |

Tree limbs on levee toe. (Spring 2020)

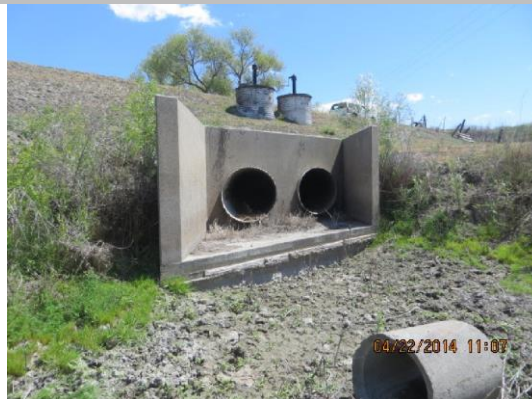
Photo 1 of 3 : UCIP_FA_2020_62457_62219.jpg

Slidegate in CMP riser, concrete headwall and pipe visible on WS slope.

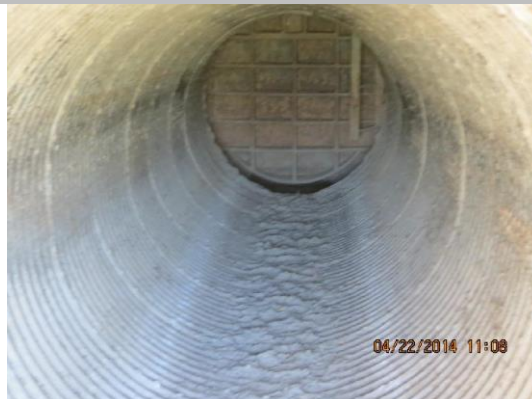
Photo 3 of 3 : UCIP_FA_2020_62457_62218.jpg

Inside pipe at LS toe.

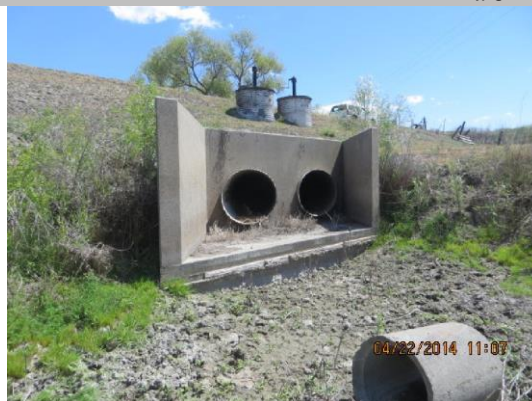
Photo 1 of 3 : UCIP_FA_2020_62458_62216.jpg

Concrete headwall, pipe, and slidegate in CMP riser on WS of levee.

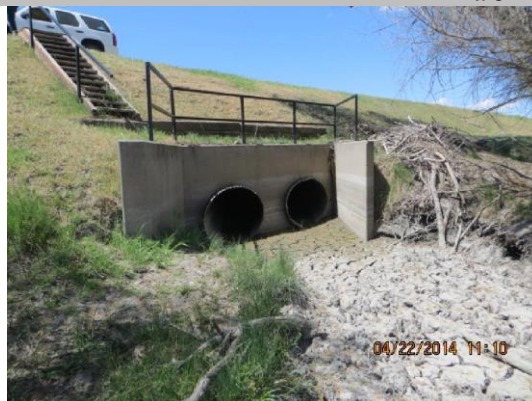
Photo 2 of 3 : UCIP_FA_2020_62458_62214.jpg

Stairs, concrete headwall and pipe on LS toe.

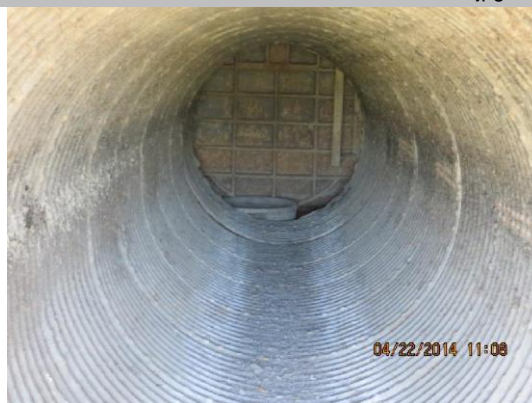
Photo 3 of 3 : UCIP_FA_2020_62458_62215.jpg

Inside pipe on WS toe.

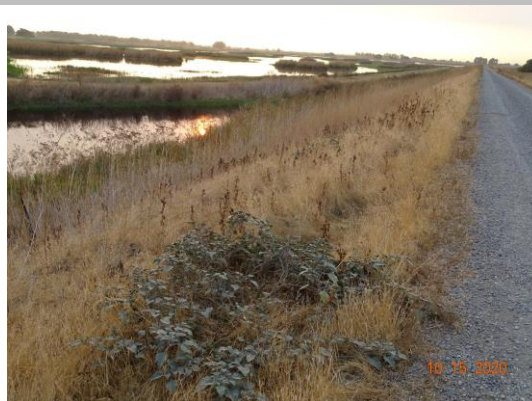
Photo 1 of 1 : FA_2020_NA0010_123_108_20201028_00308.jpg

Looking upstream along the landside slope. (Fall 2020)

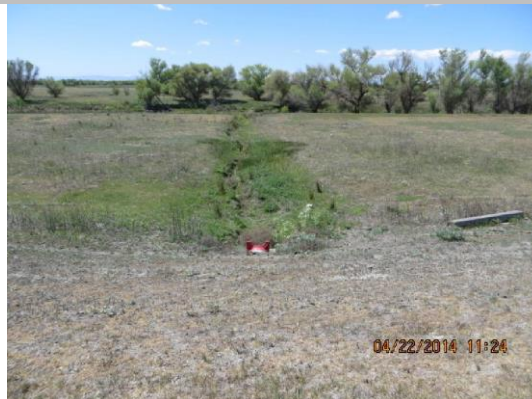
Photo 1 of 3 : UCIP_FA_2020_62459_62221.jpg

Headwall, flapgate, and pipe at WS toe.

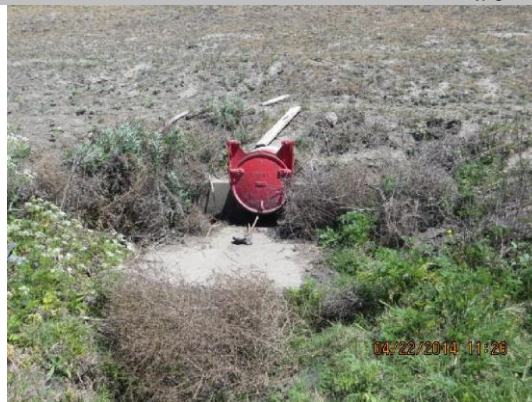
Photo 2 of 3 : UCIP_FA_2020_62459_62223.jpg

Headwall, flapgate, and pipe at WS toe.

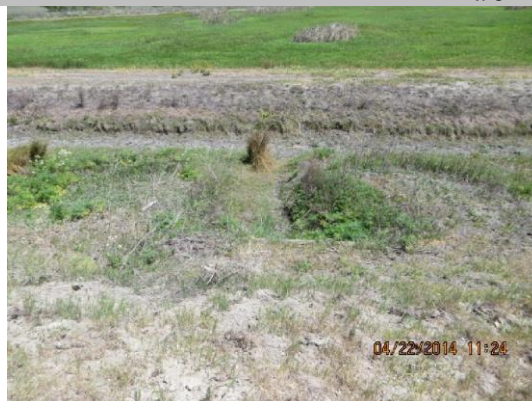
Photo 3 of 3 : UCIP_FA_2020_62459_62222.jpg

Concrete headwall and pipe at LS toe.

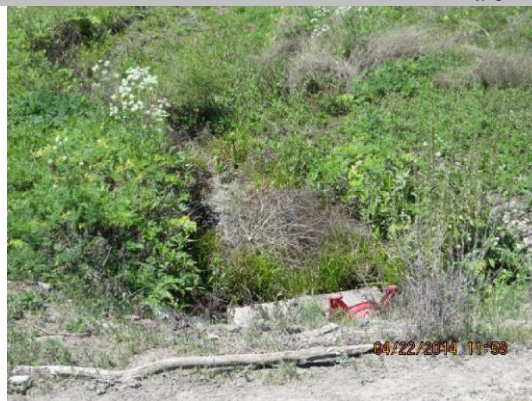
Photo 1 of 3 : UCIP_FA_2020_62460_62225.jpg

Headwall, flapgate, and pipe on WS toe.

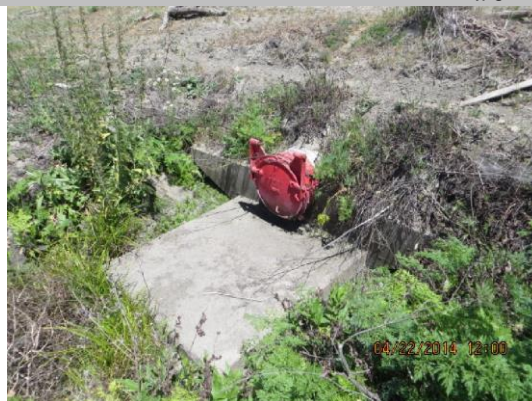
Photo 2 of 3 : UCIP_FA_2020_62460_62227.jpg

Headwall, flapgate, and pipe on WS toe.

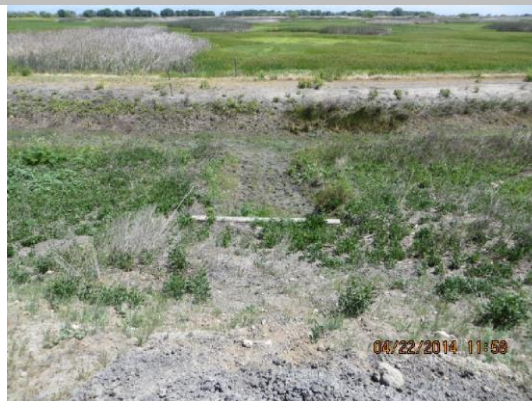
Photo 3 of 3 : UCIP_FA_2020_62460_62226.jpg

Headwall and pipe on LS toe.

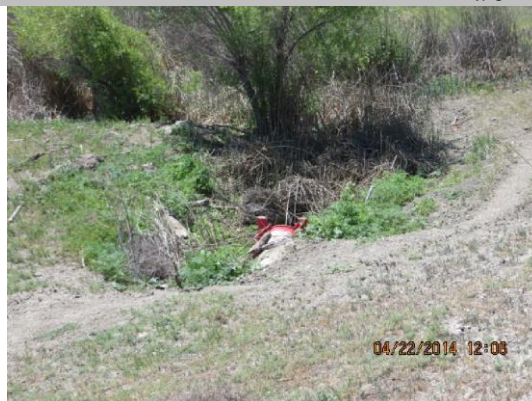
Photo 1 of 3 : UCIP_FA_2020_62461_62230.jpg

Headwall, flapgate, and pipe on WS toe.
