Flood Control Project Maintenance Levee Inspections

Fall 2020 Levee Maintenance Deficiency Summary Report

San Joaquin River Basin

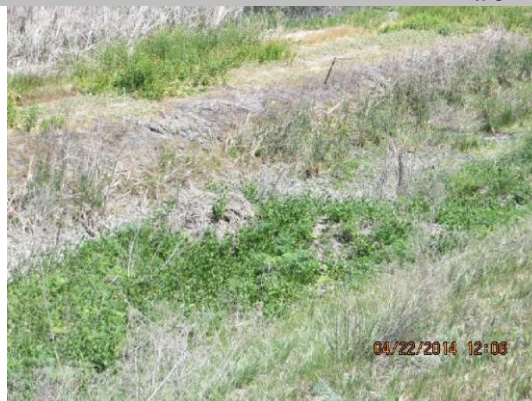
Photo 3 of 3 : UCIP_FA_2020_62461_62231.jpg

Headwall and pipe on LS toe.

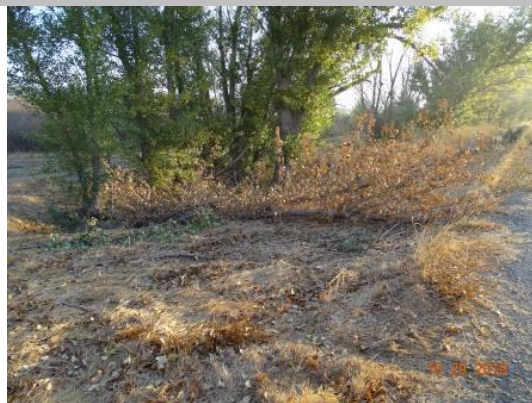
Photo 1 of 1 : FA_2020_NA0010_123_158_20200901_00027.jpg

View of downed tree limb on the landside slope. (Fall 2019)

| Tree limb on the landside slope should be removed. | | | | | |

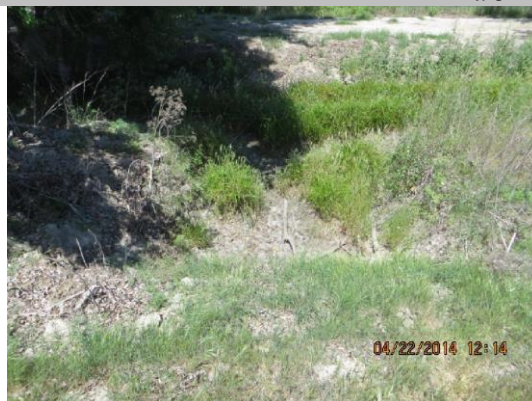
Photo 3 of 3 : UCIP_FA_2020_62462_62239.jpg

Headwall and pipe on LS toe.

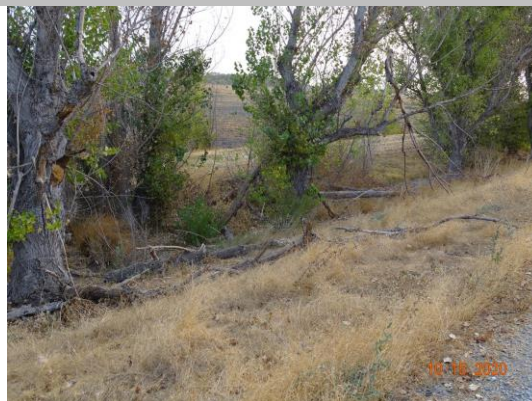
Photo 1 of 1 : FA_2020_NA0010_123_2_20201028_00309.jpg

| There are several downed trees on landside toe. | | | | | |

Looking west at down tree at landward toe. (Fall 2020)

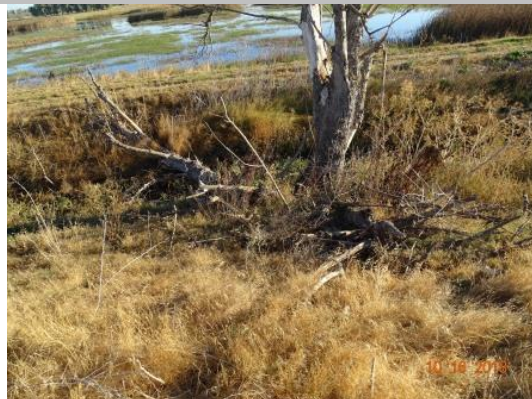
Photo 1 of 1 : FA_2020_NA0010_123_150_20200901_00025.jpg

| There are tree trimmings on the levee slope and toe. | | | | | |

Tree trimmings on landside slope and toe. (Fall 2018)

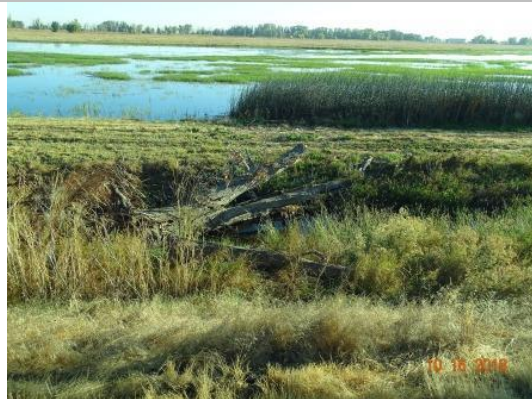
Photo 1 of 1 : FA_2020_NA0010_123_152_20200901_00026.jpg

| There is a tree trunk on landside toe. | | | | | |

Tree trunk on landside toe. (Fall 2018)

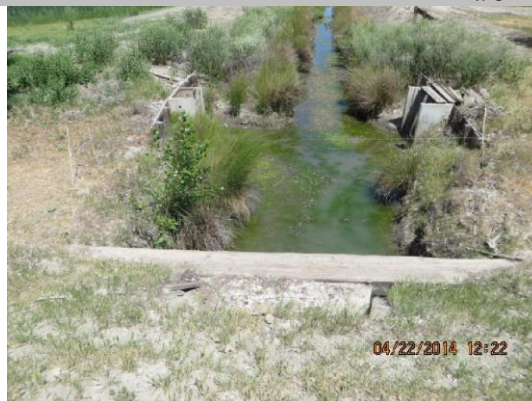
Photo 1 of 3 : UCIP_FA_2020_62463_62244.jpg

DS_ID:19708
FS_ID:62463
EP_NO: N/A
Repair Type: Non-Urgent
EVAL Issue:
Crossing Status: Found
UCIP Comments: 04/22/2014 Some erosion around headwall on the WS toe and there are animal burrows on both slopes. (W. Wylie - DWR UCIP)
FIELD_STRUCT_DESC: 48-inch corrugated metal gravity drainage pipe through the levee, 10 feet below the crown. Flap gate on the waterside (WS) end. Flashboard attachment in concrete U-shaped headwall on the landside (LS) end. Concrete U-shaped headwall on the WS end. [Additional Reference(s): DWR Levee Log, 2002 (HLM 13.40), listed as a 48-inch corrugated metal pipe (CMP). USACE San Joaquin O&M Manual, Unit 601 Part 1 (SJR601.1), 1967, Revised 25 May 2011, (HLM 13.40), listed as a 48-inch CMP].
FS Date: 4/22/2014

Headwall and pipe on LS toe.

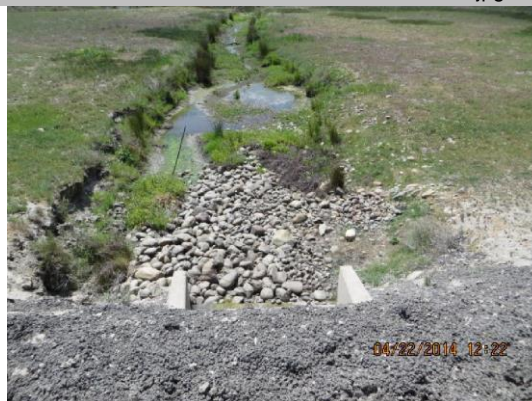
Photo 2 of 3 : UCIP_FA_2020_62463_62243.jpg

Headwall, flapgate, and pipe on WS toe.

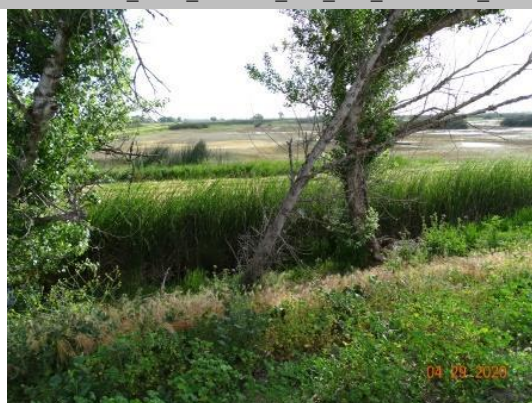
Photo 1 of 1 : FA_2020_NA0010_123_209_20200901_00036.jpg

Dead tree falling over on the landside toe. (Spring 2020)

| Dead tree should be removed before it can damage the levee. | | | | | |

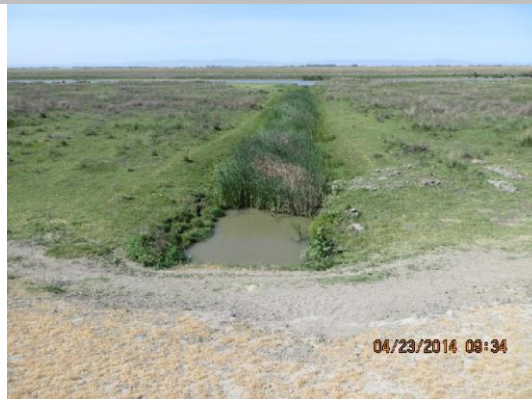
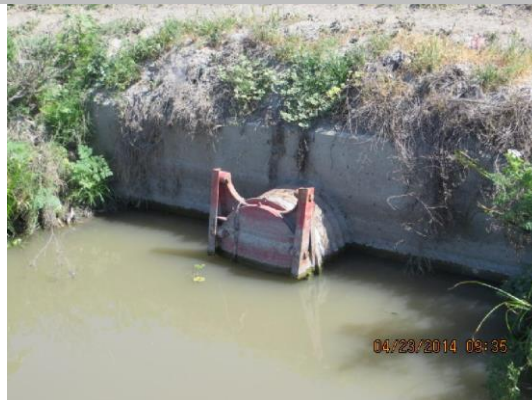
| DS_ID:19710 FS_ID:62438 EP_NO: N/A Repair Type: No Action Needed EVAL Issue: Crossing Status: Found UCIP Comments: FIELD_STRUCT_DESC: 24-inch corrugated metal gravity drainage pipe through the levee, 12.4 feet below the crown. Flap gate on the waterside (WS) end. Concrete headwall on each end. [Additional Reference(s): DWR Levee Log, 2002 (HLM 13.84), listed as a 24-inch corrugated metal pipe (CMP). USACE San Joaquin O&M Manual, Unit 601 Part 1 (SJR601.1), 1967, Revised 25 May 2011, (HLM 13.83), listed as a 24-inch CMP] FS Date: 4/23/2014 4:17:00 PM | | | | | | |

Headwall, flapgate, and pipe on WS toe.

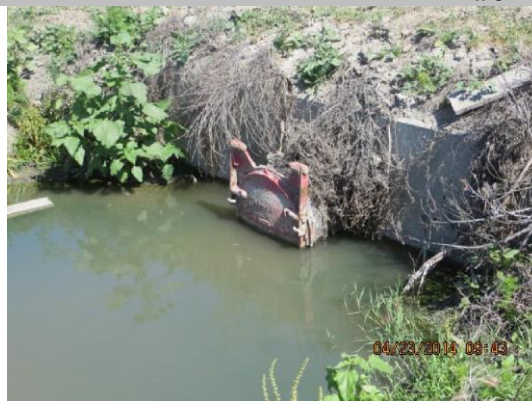
Headwall, pipe, and flapgate on WS toe.

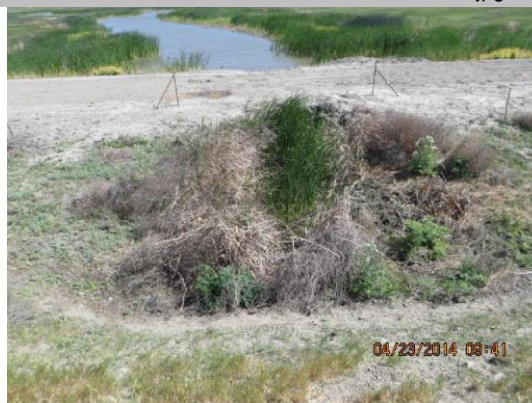
Concrete weir inlet at LS toe.

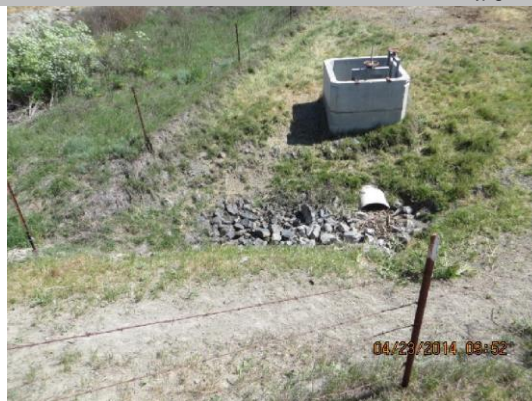
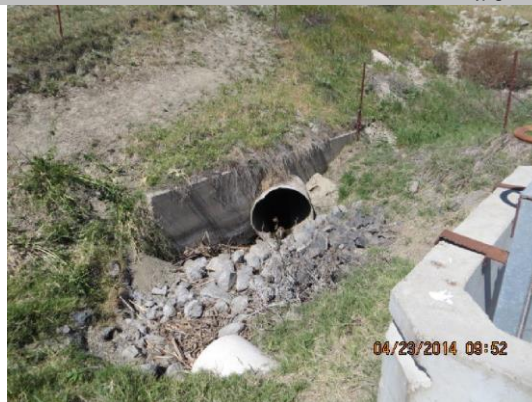
| DS_ID:19712 FS_ID:62440 EP_NO: N/A Repair Type: Non-Urgent EVAL Issue: Crossing Status: Found UCIP Comments: 04/23/2014 Minor erosion at headwall on WS toe. (W. Wylie - DWR UCIP) FIELD_STRUCT_DESC: 36-inch corrugated metal gravity drainage pipe through the levee, 11.9 feet below the crown. Flap gate on the waterside (WS) end. Concrete headwall on each end. [Additional Reference(s): DWR Levee Log, 2002 (HLM 15.08), listed as a 36-inch corrugated metal pipe (CMP). USACE San Joaquin O&M Manual, Unit 601 Part 1 (SJR601.1), 1967, Revised 25 May 2011, (HLM 15.09), listed as a 36-inch CMP] FS Date: 4/23/2014 | | | | | |

Headwall and inlet on LS toe.

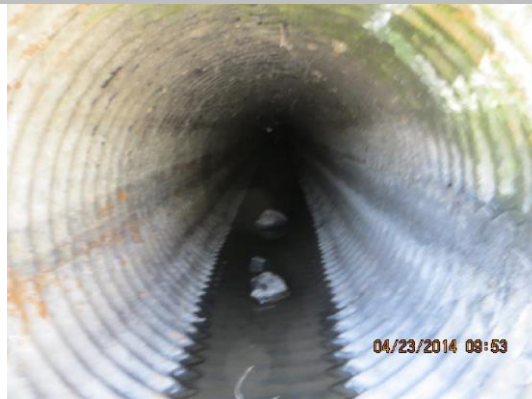
Inside pipe at LS toe.

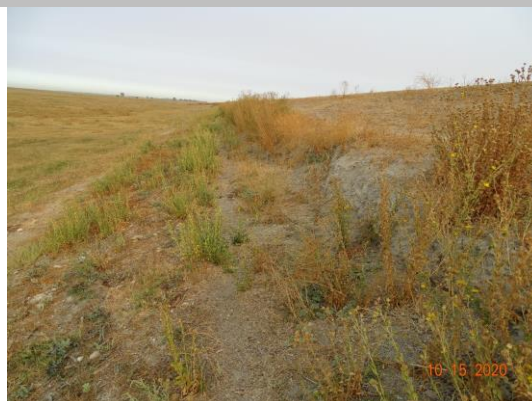
Erosion along the waterside slope. (Fall 2020)

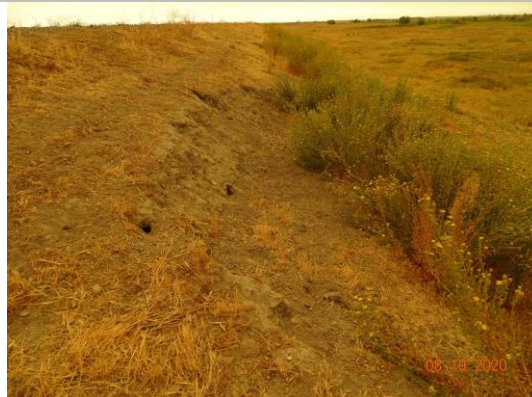
8/19/2020: View of the erosion pocket looking upstream. The erosion has cut into the levee prism.

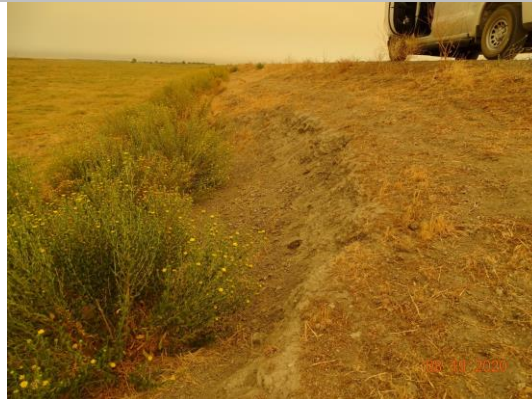
8/19/2020: Another view of the erosion pocket, looking downstream.

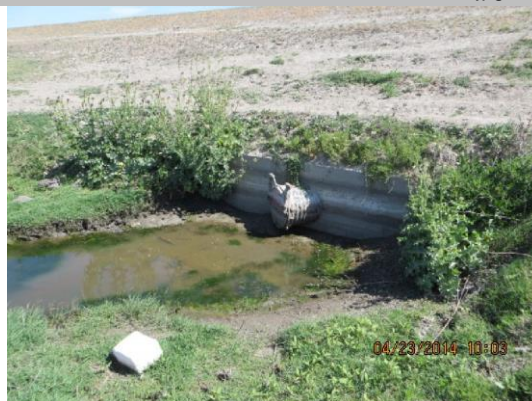
| DS_ID:19713 FS_ID:62441 EP_NO: N/A Repair Type: Non-Urgent EVAL Issue: Crossing Status: Found UCIP Comments: 04/23/2014 Sediment buildup in pipe visible from landward side--recommend contacting owner to clear pipe. (W. Wylie - DWR UCIP) FIELD_STRUCT_DESC: 24-inch corrugated metal gravity drainage pipe through the levee, 11 feet below the crown. Flap gate on the waterside (WS) end. Concrete headwall on each end. [Additional Reference(s): DWR Levee Log, 2002 (HLM 15.74), listed as a 24-inch corrugated metal pipe (CMP). USACE San Joaquin O&M Manual, Unit 601 Part 1 (SJR601.1), 1967, Revised 25 May 2011, (HLM 15.74), listed as a 24-inch CMP] FS Date: 4/23/2014 | | | | | |

Headwall, pipe, and flapgate on WS toe.

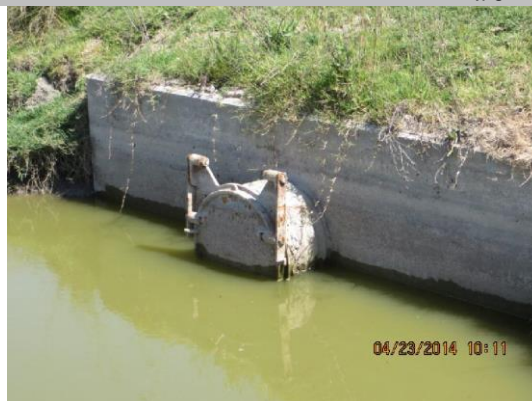
| Comment Code |
|---|
| DS_ID:19715 FS_ID:62443 EP_NO: N/A Repair Type: Non-Urgent EVAL Issue: Crossing Status: Found UCIP Comments: 04/23/2014 Excess vegetation at inlet on LS toe should be cleared. (W. Wylie - DWR UCIP) FIELD_STRUCT_DESC: 26-inch corrugated metal gravity drainage pipe through the levee, 12 feet below the crown. Flap gate on the waterside (WS) end. Concrete headwall on the landside (LS) end. Concrete saddle and apron on the WS end. [Additional Reference(s): DWR Levee Log, 2002 (HLM 15.79), listed as a 24-inch corrugated metal pipe (CMP). USACE San Joaquin O&M Manual, Unit 601 Part 1 (SJR601.1), 1967, Revised 25 May 2011, (HLM 15.80), listed as a 24-inch CMP] FS Date: 4/23/2014 |

Headwall, pipe, and flapgate on WS toe.

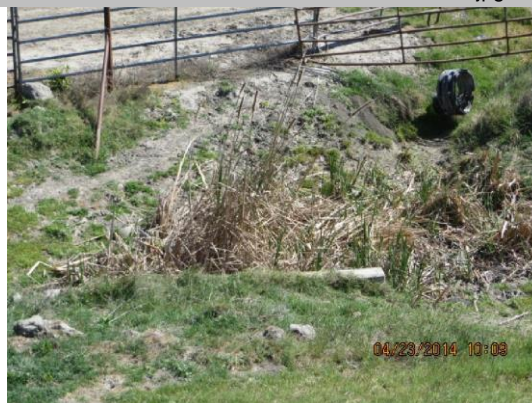
Headwall and pipe visible at LS toe.

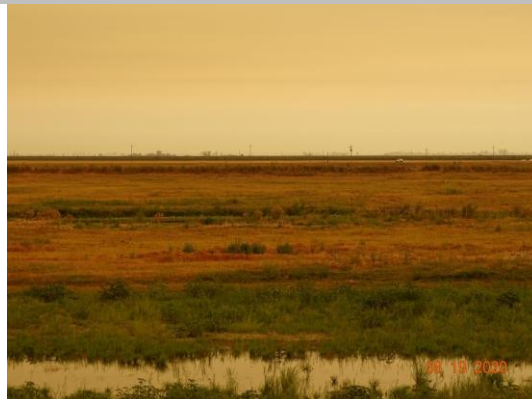
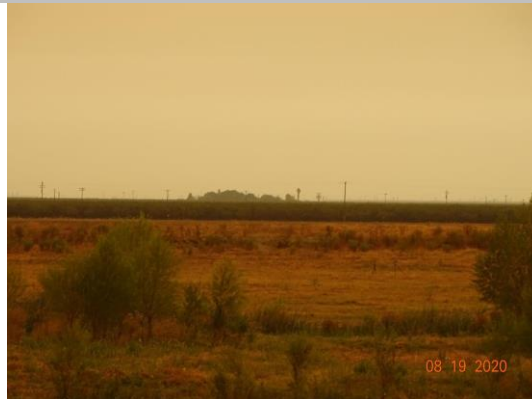
08/19/2020: Due to ongoing construction both up and downstream, this site could not be accessed and only be viewed from the opposite bank across the bypass. Unable to determine if the conditions changed since the previous inspection.

09/10/2019: The erosion has become worse during the past 2 flood seasons. The erosion length has increased to approximately 200 ft from 55 ft. Signs of animal activity were observed.

8/19/2020: View of the erosion from across the bypass.

8/19/2020: Another view of the erosion from across the bypass.

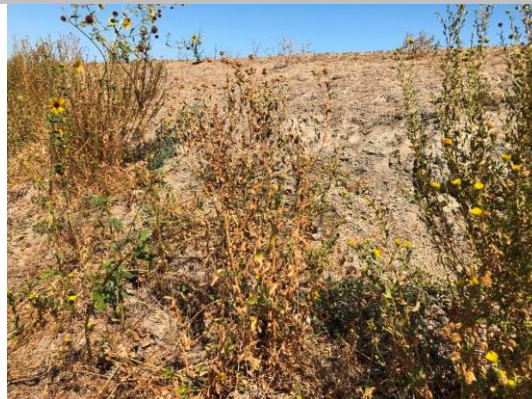
9/10/2019: Looking at the erosion from the levee toe. Note the dense vegetation.

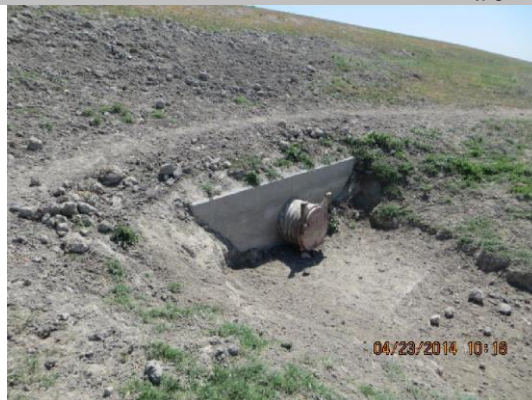
| DS_ID:19716 FS_ID:62444 EP_NO: N/A Repair Type: Non-Urgent EVAL Issue: Crossing Status: Found UCIP Comments: 04/23/2014 Pipe heavily silted on LS toe. (W. Wylie - DWR UCIP) FIELD_STRUCT_DESC: 24-inch corrugated metal gravity drainage pipe through the levee, 10.5 feet below the crown. Flap gate on the waterside (WS) end. Concrete headwall on each end. [Additional Reference(s): DWR Levee Log, 2002 (HLM 16.66), listed as a 24-inch corrugated metal pipe (CMP). USACE San Joaquin O&M Manual, Unit 601 Part 1 (SJR601.1), 1967, Revised 25 May 2011, (HLM 16.67), listed as a 24-inch CMP] FS Date: 4/23/2014 | | | | | |

Headwall, flapgate, and pipe visible on WS toe.

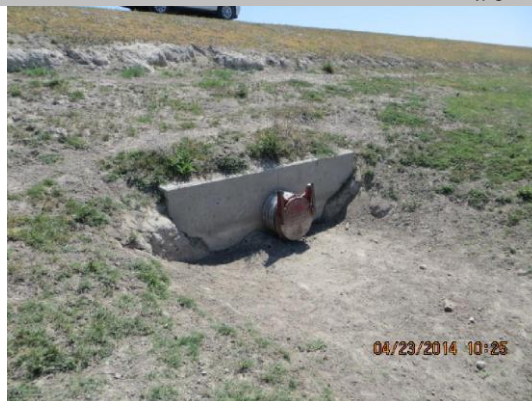
Headwall, flapgate, and pipe visible on WS toe.

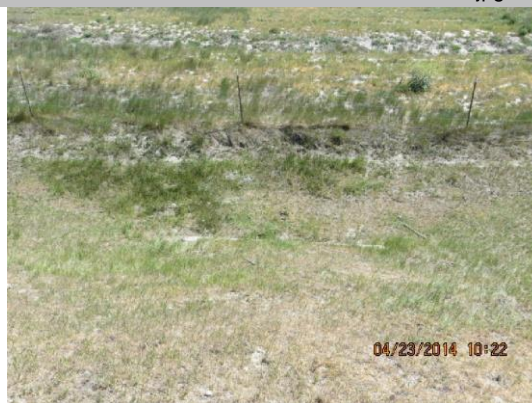
Headwall and pipe visible on LS toe.

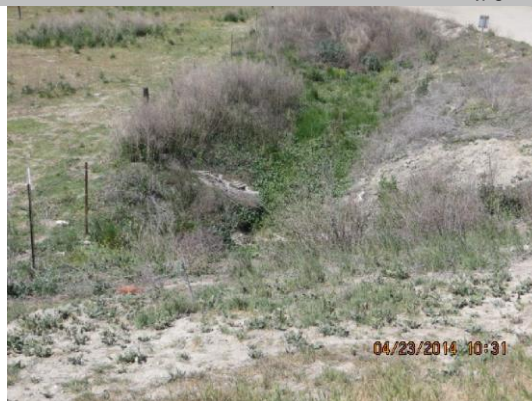
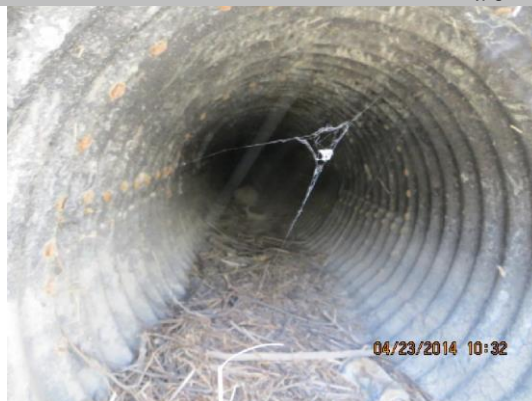
| DS_ID:19743 FS_ID:62446 EP_NO: N/A Repair Type: Non-Urgent EVAL Issue: Crossing Status: Found UCIP Comments: 04/23/2014 Sediment buildup in pipe visible from landward side--recommend contacting owner to clear pipe. (W. Wylie - DWR UCIP) FIELD_STRUCT_DESC: 24-inch corrugated metal gravity drainage pipe through the levee, 9.8 feet below the crown. Flap gate on the waterside (WS) end. Concrete headwall on each end. [Additional Reference(s): DWR Levee Log, 2002 (HLM 17.52), listed as a 24-inch corrugated metal pipe (CMP). USACE San Joaquin O&M Manual, Unit 601 Part 1 (SJR601.1), 1967, Revised 25 May 2011, (HLM 17.52), listed as a 24-inch CMP] FS Date: 4/23/2014 | | | | | |

Headwall, pipe, and flapgate visible on WS toe.

Pipe and headwall visible on LS toe.

Inside pipe on LS toe.

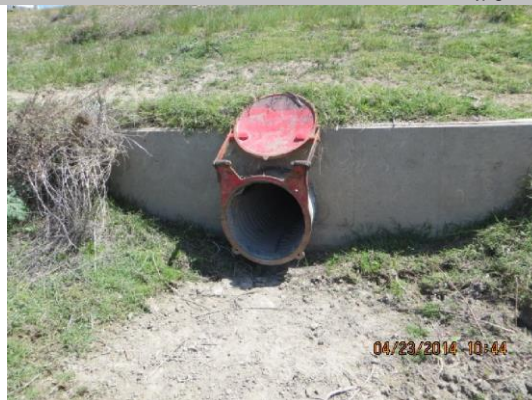
| DS_ID:19745 FS_ID:62465 EP_NO: N/A Repair Type: Non-Urgent EVAL Issue: Crossing Status: Found UCIP Comments: 04/23/2014 Animal burrows in levee on both slopes. (W. Wylie - DWR UCIP) FIELD_STRUCT_DESC: 24-inch corrugated metal gravity drainage pipe through the levee, 12.4 feet below the crown. Flap gate on the waterside (WS) end. Concrete headwall on each end. [Additional Reference(s): DWR Levee Log, 2002 (HLM 18.07), listed as a 24-inch corrugated metal pipe (CMP). USACE San Joaquin O&M Manual, Unit 601 Part 1 (SJR601.1), 1967, Revised 25 May 2011, (HLM 18.07), listed as a 24-inch CMP] FS Date: 4/23/2014 | | | | | |

Headwall, pipe, and flapgate on WS toe.

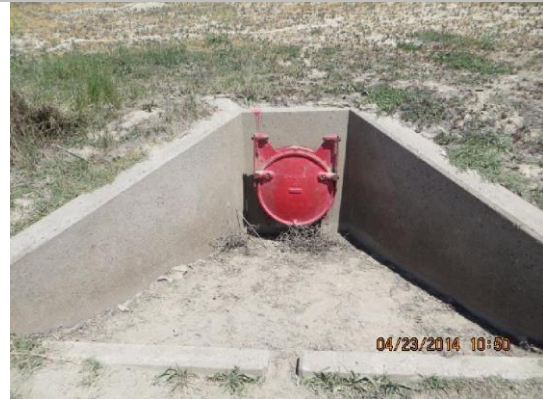
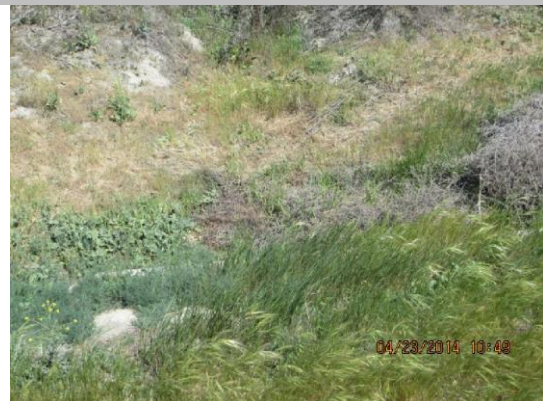
| DS_ID:19746 FS_ID:62466 EP_NO: N/A Repair Type: Non-Urgent EVAL Issue: Crossing Status: Found UCIP Comments: 04/23/2014 Dense vegetation limits the inspector's visibility to identify signs of pipe failure (leaks) along the landward slope. Recommend removing vegetation along pipe alignment to conduct proper inspection of structure. (W. Wylie - DWR UCIP) FIELD_STRUCT_DESC: 24-inch corrugated metal gravity drainage pipe through the levee, 10 feet below the crown. Flap gate on the waterside (WS) end. Concrete headwall on the landside (LS) end. Concrete U-shaped headwall on the WS end. [Additional Reference(s): DWR Levee Log, 2002 (HLM 18.68), listed as a 24-inch corrugated metal pipe (CMP). USACE San Joaquin O&M Manual, Unit 601 Part 1 (SJR601.1), 1967, Revised 25 May 2011, (HLM 18.68), listed as a 24-inch CMP] FS Date: 4/23/2014 | | | | | | |

Headwall, pipe and flapgate visible on WS toe.

Headwall and pipe on LS toe.

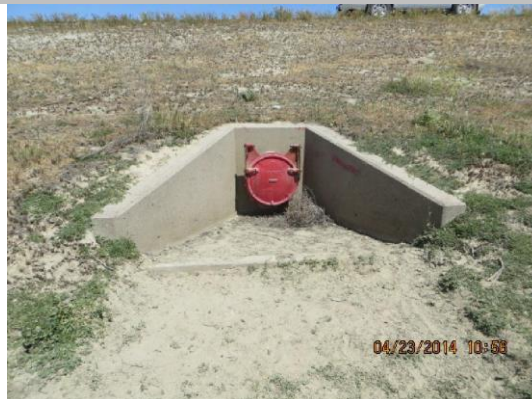
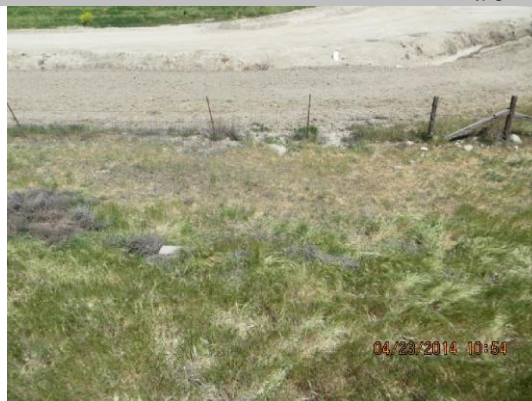
DS_ID:19747
FS_ID:62467
EP_NO: N/A
Repair Type: Non-Urgent
EVAL Issue:
Crossing Status: Found
UCIP Comments: 04/23/2014 Sediment buildup in pipe visible from landward side--recommend contacting owner to clear pipe. (W. Wylie - DWR UCIP)
FIELD_STRUCT_DESC: 24-inch corrugated metal gravity drainage pipe through the levee, 10 feet below the crown. Flap gate on the waterside (WS) end. Concrete headwall on the landside (LS) end. Concrete U-shaped headwall on the WS end. [Additional Reference(s): DWR Levee Log, 2002 (HLM 19.13), listed as a 24-inch corrugated metal pipe (CMP). USACE San Joaquin O&M Manual, Unit 601 Part 1 (SJR601.1), 1967, Revised 25 May 2011, (HLM 19.11), listed as a 24-inch CMP]
FS Date: 4/23/2014

Headwall, pipe, and flapgate visible on WS toe.

Headwall and pipe visible on LS toe.

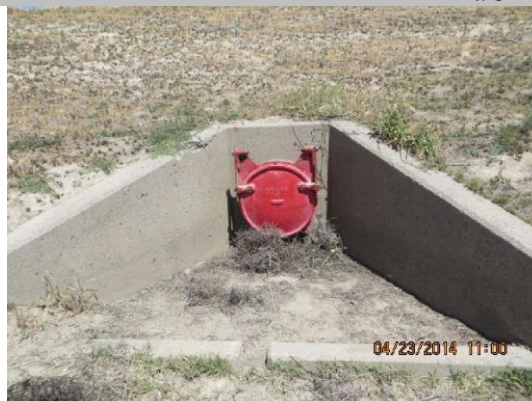
Photo 2 of 3 : UCIP_FA_2020_62468_62511.jpg

Headwall, pipe, and flapgate visible on WS toe.

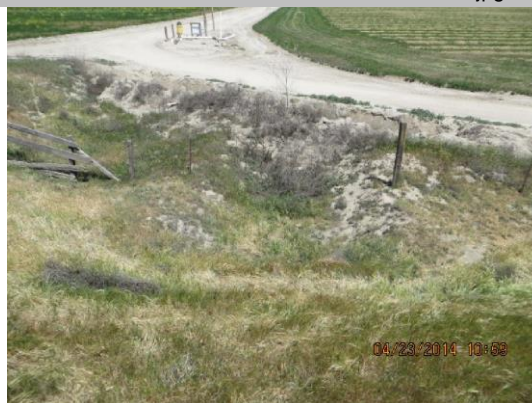
Photo 3 of 3 : UCIP_FA_2020_62468_62510.jpg

Headwall and pipe visible on LS toe.

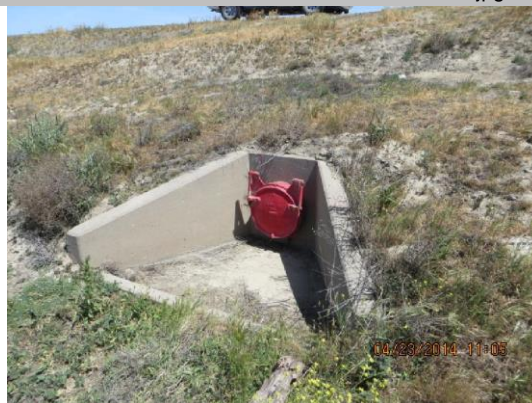
Photo 2 of 3 : UCIP_FA_2020_62469_62516.jpg

Headwall, pipe, and flapgate visible on WS toe.

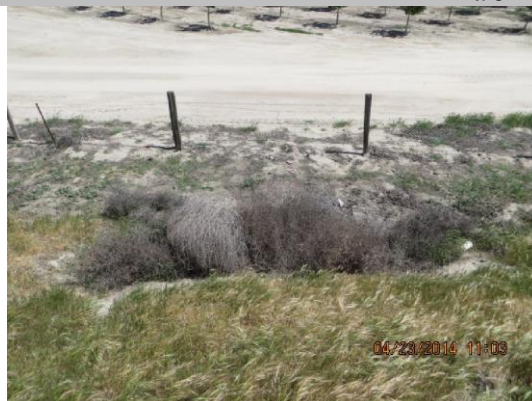
Photo 3 of 3 : UCIP_FA_2020_62469_62515.jpg

Headwall and pipe visible on LS toe.

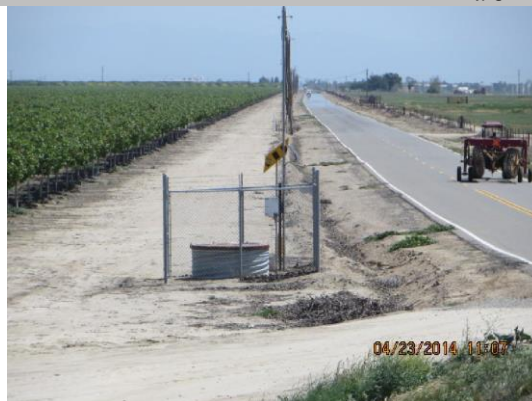
Photo 1 of 2 : UCIP_FA_2020_39345_71477.jpg

DS_ID:24868
 FS_ID:39345
 EP_NO: N/A
 Repair Type: Non-Urgent
 EVAL Issue:
 Crossing Status: Indicator Found
 UCIP Comments: 04/23/2014 Markers closer to the levee may be necessary to properly mark pipe crossing location. (DWR UCIP - W. Wylie)
 FIELD_STRUCT_DESC: Steel natural gas pipeline of an unknown size through the levee, at an unknown depth. Corrugated metal pipe (CMP) riser and gas line marker off the landside (LS) toe.
 FS Date: 4/22/2014

Gasline marker off LS toe.

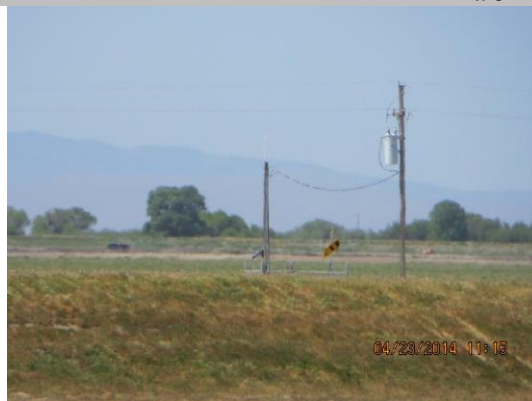
Photo 2 of 2 : UCIP_FA_2020_39345_71476.jpg

Gasline marker off LS of opposite bank.

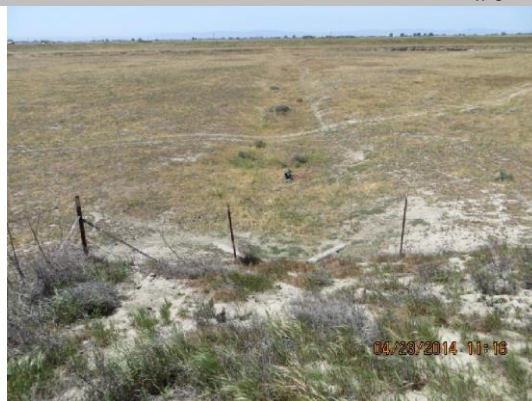
Photo 1 of 3 : UCIP_FA_2020_62470_62519.jpg

DS_ID:19778
 FS_ID:62470
 EP_NO: N/A
 Repair Type: Non-Urgent
 EVAL Issue:
 Crossing Status: Found
 UCIP Comments: 04/23/2014 Dense vegetation limits the inspector's visibility to identify signs of pipe failure (leaks) along the landward slope. Recommend removing vegetation along pipe alignment to conduct proper inspection of structure. Sediment buildup in pipe visible from landward side--recommend contacting owner to clear pipe. (W. Wylie - DWR UCIP)
 FIELD_STRUCT_DESC: 24-inch corrugated metal gravity drainage pipe through the levee, 9.7 feet below the crown. Flap gate on the waterside (WS) end. Concrete headwall on the landside (LS) end. Concrete U-shaped headwall on the WS end. [Additional Reference(s): DWR Levee Log, 2002 (HLM 19.50), listed as a 24-inch corrugated metal pipe (CMP). USACE San Joaquin O&M Manual, Unit 601 Part 1 (SJR601.1), 1967, Revised 25 May 2011, (HLM 19.50), listed as a 24-inch CMP]

Headwall, pipe, and flapgate visible on WS toe.

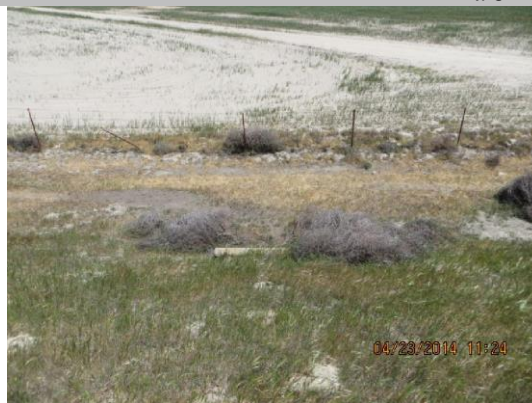
Photo 1 of 3 : UCIP_FA_2020_62521_62525.jpg

Headwall and pipe visible on LS toe.

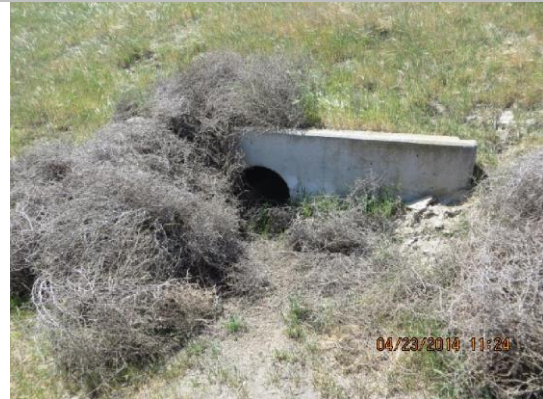
Photo 2 of 3 : UCIP_FA_2020_62521_62524.jpg

Headwall and pipe visible on LS toe.

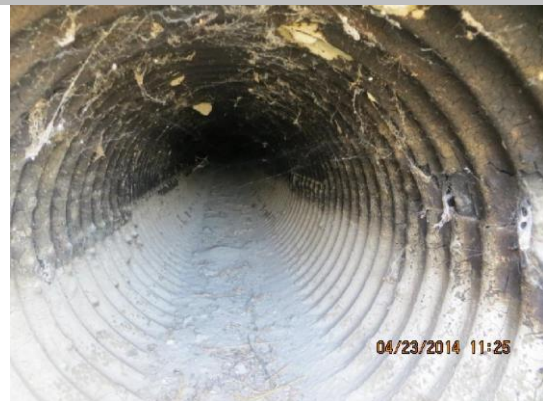
Photo 3 of 3 : UCIP_FA_2020_62521_62523.jpg

Inside pipe on LS toe.

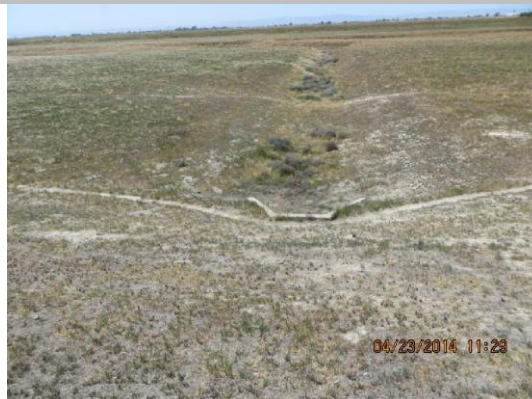
Photo 1 of 3 : UCIP_FA_2020_62472_62529.jpg

Headwall, pipe, and flapgate visible on WS toe.

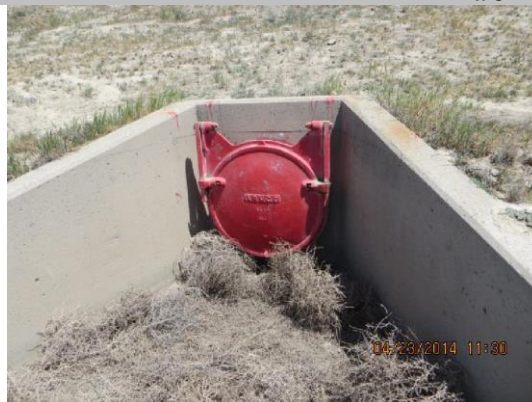
Photo 2 of 3 : UCIP_FA_2020_62472_62530.jpg

Headwall, pipe, and flapgate visible on WS toe.

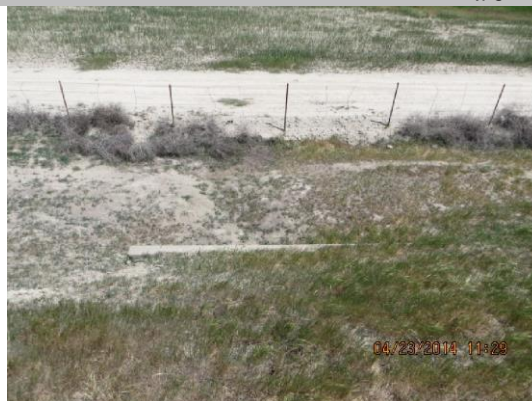
Photo 3 of 3 : UCIP_FA_2020_62472_62528.jpg

Headwall and pipe visible on LS toe.

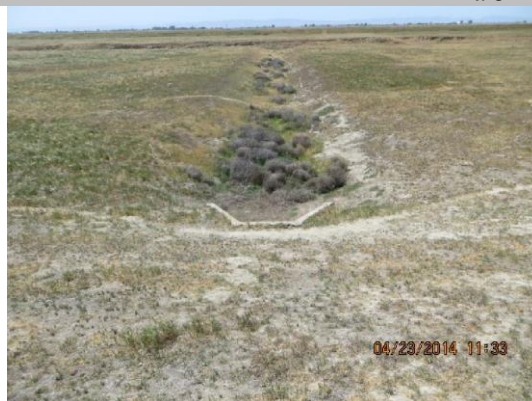
Photo 1 of 3 : UCIP_FA_2020_62522_62533.jpg

Headwall, pipe, and flapgate visible on WS toe.

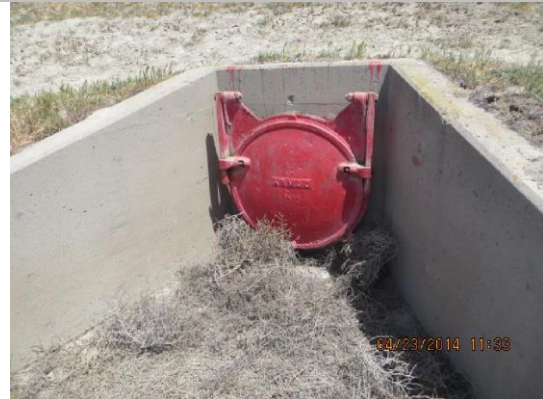
Photo 2 of 3 : UCIP_FA_2020_62522_62532.jpg

Headwall, pipe, and flapgate visible on WS toe.

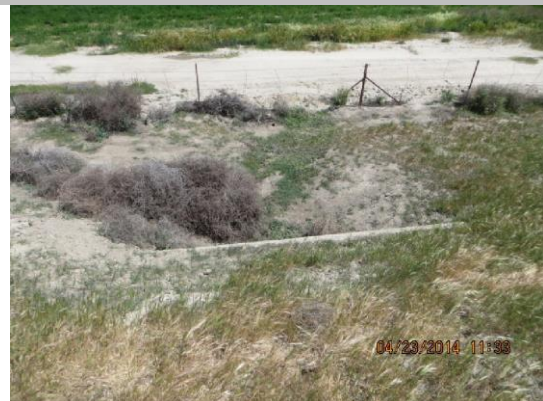
Photo 3 of 3 : UCIP_FA_2020_62522_62534.jpg

Headwall and pipe visible on LS toe.

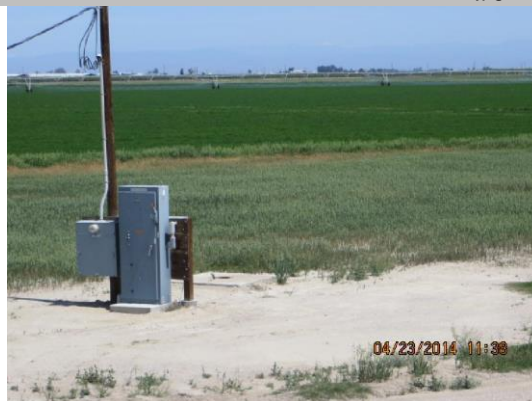
Photo 1 of 1 : UCIP_FA_2020_34759_62537.jpg

| DS_ID:19782 FS_ID:34759 EP_NO: 13828 Repair Type: Non-Urgent EVAL Issue: Crossing Status: Not Found UCIP Comments: FIELD_STRUCT_DESC: *DELETE* NOT INSTALLED THROUGH THE LEVEE. 24-inch steel irrigation pipe through the levee, 4.0 feet below the crown. Pump missing from pad on the landward side. Steel cutoff wall around pipe at center of levee. Siphon breaker on apex of pipe on landward shoulder. Pre-existing ditch runs from waterward toe to channel. Pipe extends from pump to the channel. Rock revetment on the cut slopes of the inlet channel. (Permit No. 13828-1988) FS Date: 4/23/2014 | | | | | | |

Well head visible off LS toe.

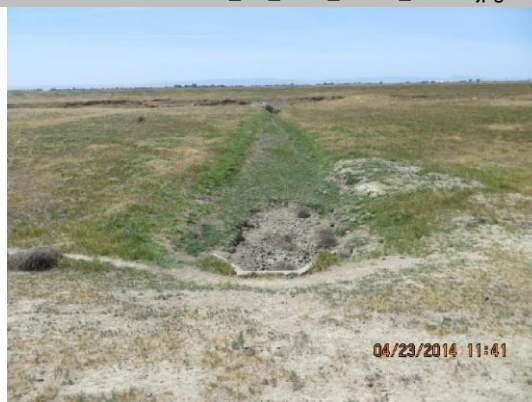
Photo 1 of 3 : UCIP_FA_2020_62474_62539.jpg

Headwall, pipe, and flapgate visible on WS toe.

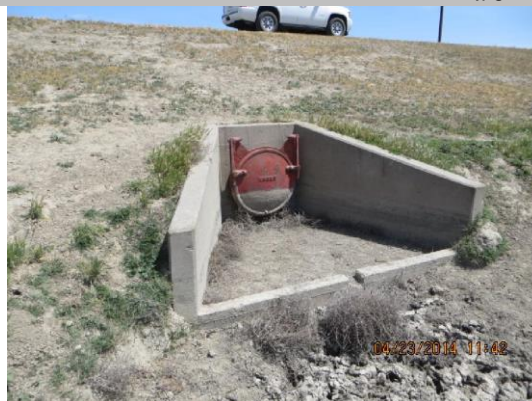
Photo 2 of 3 : UCIP_FA_2020_62474_62541.jpg

Headwall, pipe, and flapgate visible on WS toe.

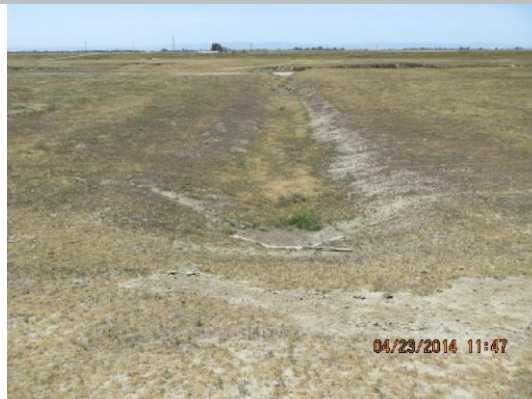
Photo 1 of 3 : UCIP_FA_2020_62523_62544.jpg

DS_ID:19784
FS_ID:62523
EP_NO: N/A
Repair Type: Non-Urgent
EVAL Issue:
Crossing Status: Found
UCIP Comments: 04/23/2014 Dense vegetation limits the inspector's visibility to identify signs of pipe failure (leaks) along the landward slope. Recommend removing vegetation along pipe alignment to conduct proper inspection of structure. (W. Wylie - DWR UCIP)
FIELD_STRUCT_DESC: 24-inch corrugated metal gravity drainage pipe through the levee, 10.5 feet below the crown. Flap gate on the waterside (WS) end. Concrete headwall on the landside (LS) end. Concrete U-shaped headwall on the WS end. [Additional Reference(s): DWR Levee Log, 2002 (HLM 20.58), listed as a 24-inch corrugated metal pipe (CMP). USACE San Joaquin O&M Manual, Unit 601 Part 1 (SJR601.1), 1967, Revised 25 May 2011, (HLM 20.59), listed as a 24-inch CMP]
FS Date: 4/23/2014

Headwall, pipe, and flapgate visible on WS toe.

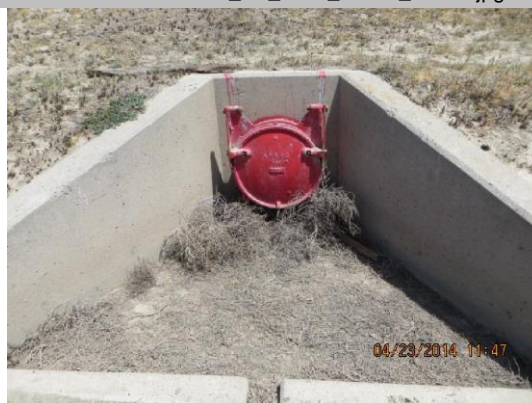
Photo 2 of 3 : UCIP_FA_2020_62523_62543.jpg

Headwall, pipe, and flapgate visible on WS toe.

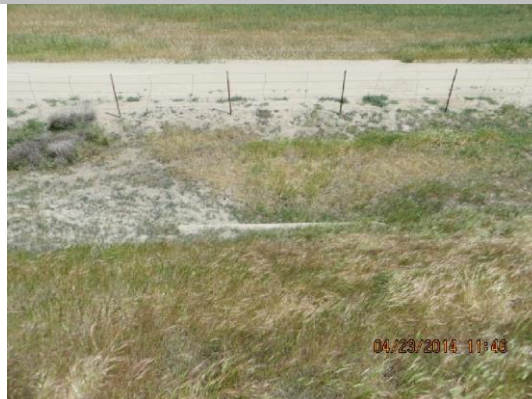
Photo 3 of 3 : UCIP_FA_2020_62523_62545.jpg

Headwall and pipe visible on LS toe.

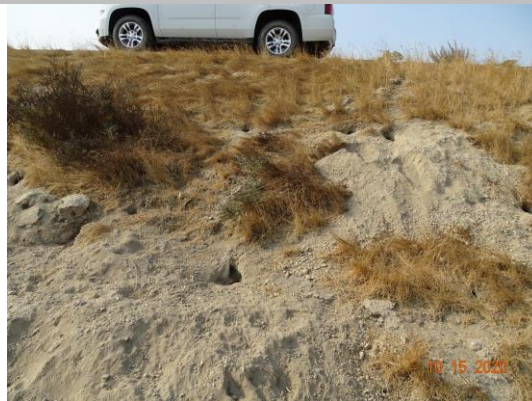
Photo 1 of 1 : FA_2020_NA0010_123_135_20201028_00316.jpg

View of rodent burrow in the landside slope. (Fall 2020)

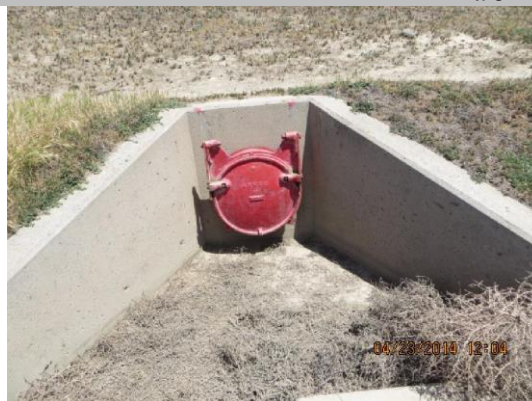
Photo 2 of 3 : UCIP_FA_2020_62476_62551.jpg

Headwall, pipe, and flapgate visible on WS toe.

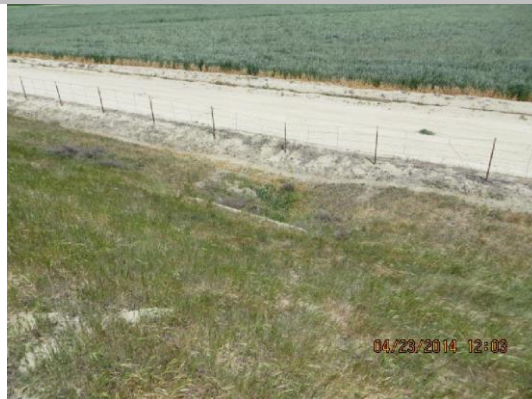
Photo 3 of 3 : UCIP_FA_2020_62476_62550.jpg

Headwall and pipe visible on LS toe.

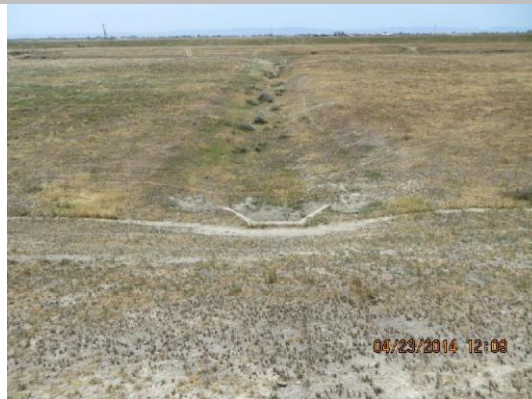
Photo 1 of 3 : UCIP_FA_2020_62524_62555.jpg

DS_ID:19786
FS_ID:62524
EP_NO: N/A
Repair Type: Non-Urgent
EVAL Issue:
Crossing Status: Found
UCIP Comments: 04/23/2014 Dense vegetation limits the inspector's visibility to identify signs of pipe failure (leaks) along the landward slope. Recommend removing vegetation along pipe alignment to conduct proper inspection of structure. (W. Wylie - DWR UCIP)
FIELD_STRUCT_DESC: 36-inch corrugated metal gravity drainage pipe through the levee, 12.7 feet below the crown. Flap gate on the waterside (WS) end. Concrete headwall on the landside (LS) end. Concrete U-shaped headwall on the WS end. [Additional Reference(s): DWR Levee Log, 2002 (HLM 21.43), listed as a 36-inch corrugated metal pipe (CMP). USACE San Joaquin O&M Manual, Unit 601 Part 1 (SJR601.1), 1967, Revised 25 May 2011, (HLM 21.42)]
FS Date: 4/23/2014

Headwall, pipe, and flapgate visible on WS toe.

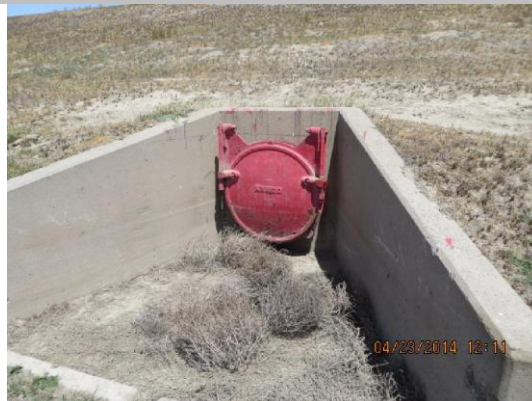
Photo 2 of 3 : UCIP_FA_2020_62524_62556.jpg

Headwall, pipe, and flapgate visible on WS toe.

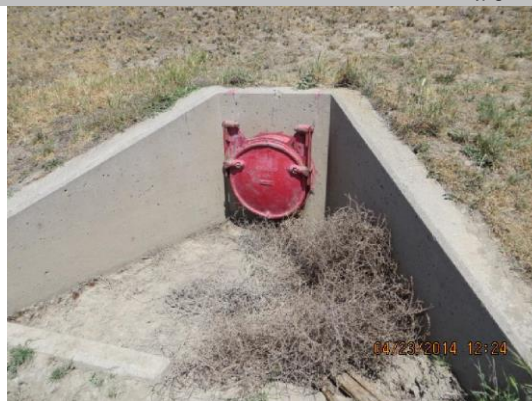
Photo 2 of 3 : UCIP_FA_2020_62478_62558.jpg

Headwall, pipe, and flapgate visible on WS toe.

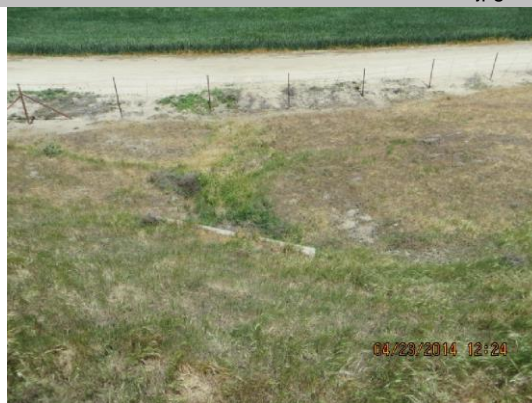
Photo 3 of 3 : UCIP_FA_2020_62478_62560.jpg

Headwall and pipe visible on LS toe.

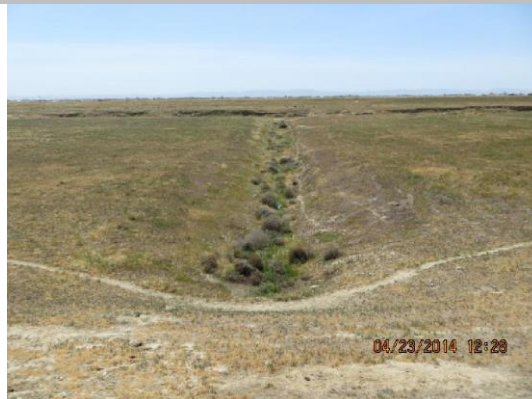
Photo 1 of 3 : UCIP_FA_2020_62479_62586.jpg

DS_ID:19788
FS_ID:62479
EP_NO: N/A
Repair Type: Non-Urgent
EVAL Issue:
Crossing Status: Found
UCIP Comments: 04/23/2014 Dense vegetation limits the inspector's visibility to identify signs of pipe failure (leaks) along the landward slope. Recommend removing vegetation along pipe alignment to conduct proper inspection of structure. (W. Wylie - DWR UCIP)
FIELD_STRUCT_DESC: 24-inch corrugated metal gravity drainage pipe through the levee, 10.7 feet below the crown. Flap gate on the waterside (WS) end. Concrete headwall on the landside (LS) end. Concrete U-shaped headwall on the WS end. [Additional Reference(s): DWR Levee Log, 2002 (HLM 21.85), listed as a 24-inch corrugated metal pipe (CMP). USACE San Joaquin O&M Manual, Unit 601 Part 1 (SJR601.1), 1967, Revised 25 May 2011, (HLM 21.85), listed as a 24-inch CMP].
FS Date: 4/23/2014

Headwall, pipe, and flapgate visible on WS toe.

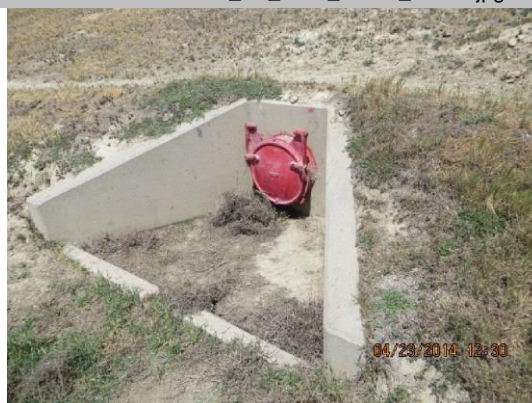
Photo 2 of 3 : UCIP_FA_2020_62479_62588.jpg

Headwall, pipe, and flapgate visible on WS toe.

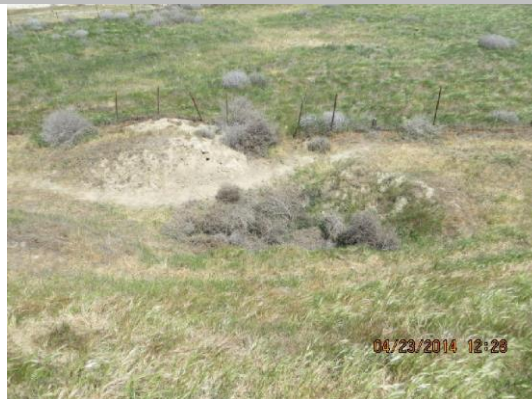
Photo 3 of 3 : UCIP_FA_2020_62479_62587.jpg

Headwall and pipe visible on LS toe.

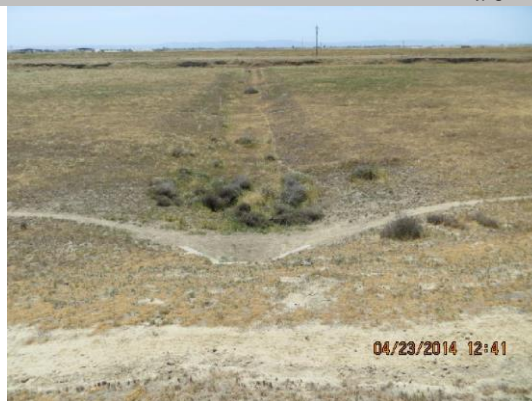
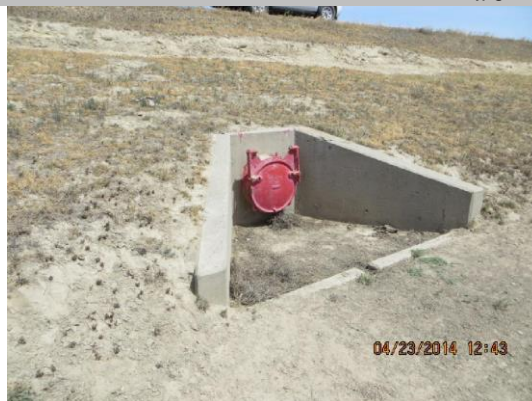
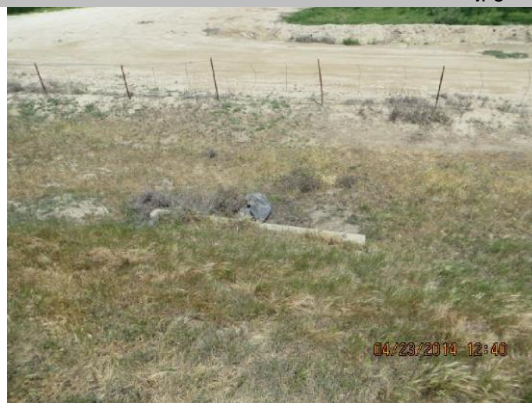
DS_ID:19789
 FS_ID:62480
 EP_NO: N/A
 Repair Type: Non-Urgent
 EVAL Issue:
 Crossing Status: Found
 UCIP Comments: 04/23/2014 Dense vegetation limits the inspector's visibility to identify signs of pipe failure (leaks) along the landward slope. Recommend removing vegetation along pipe alignment to conduct proper inspection of structure. Sediment buildup in pipe visible from landward side--recommend contacting owner to clear pipe. (W. Wylie - DWR UCIP)
 FIELD_STRUCT_DESC: 24-inch corrugated metal gravity drainage pipe through the levee, 10.2 feet below the crown. Flap gate on the waterside (WS) end. Concrete headwall on the landside (LS) end. Concrete U-shaped headwall on the WS end. [Additional Reference(s): DWR Levee Log, 2002 (HLM 22.18), listed as a 24-inch corrugated metal pipe (CMP). USACE San Joaquin O&M Manual, Unit 601 Part 1 (SJR601.1), 1967, Revised 25 May 2011, (HLM 22.19), listed as a 24-inch CMP].

Headwall, pipe, and flapgate visible on WS toe.

Headwall and pipe visible on LS toe.

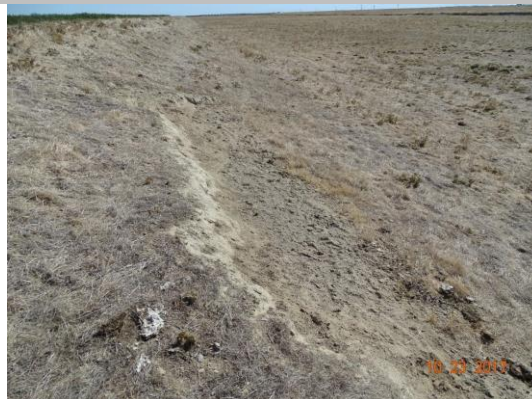
Photo 1 of 1 : FA_2020_NA0010_123_121_20200901_00010.jpg

| Waterside slope damaged by animal traffic. | | | | | |

Looking southeast at the waterside slope.

| A2 : Repair the levee slope damaged by livestock and prevent large animal access. | | | | | |

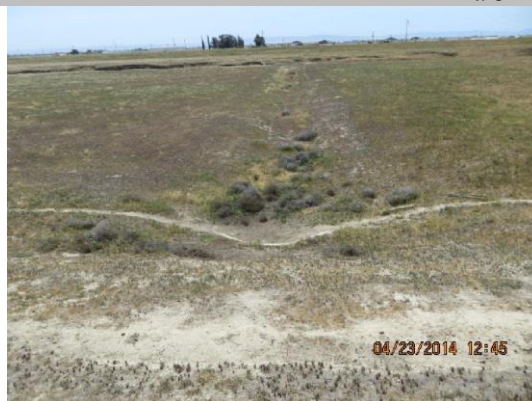
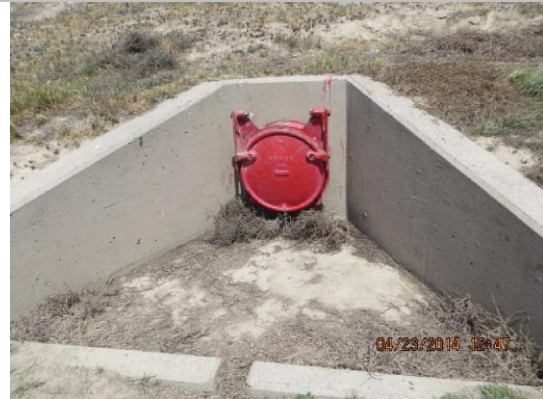
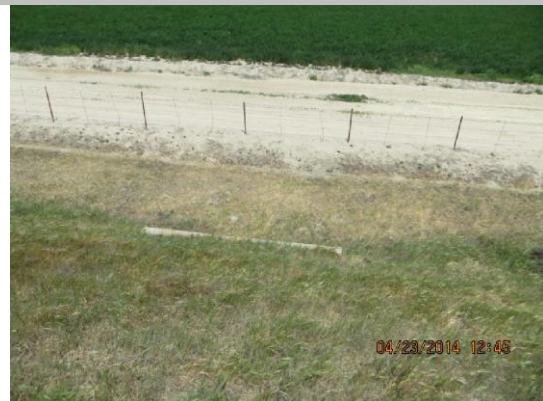
| DS_ID:19790 FS_ID:62481 EP_NO: N/A Repair Type: Non-Urgent EVAL Issue: Crossing Status: Found UCIP Comments: 04/23/2014 Dense vegetation limits the inspector's visibility to identify signs of pipe failure (leaks) along the landward slope. Recommend removing vegetation along pipe alignment to conduct proper inspection of structure. Sediment buildup in pipe visible from landward side--recommend contacting owner to clear pipe. (W. Wylie - DWR UCIP) FIELD_STRUCT_DESC: 24-inch corrugated metal gravity drainage pipe through the levee, 10.4 feet below the crown. Flap gate on the waterside (WS) end. Concrete headwall on the landside (LS) end. Concrete U-shaped headwall on the WS end. [Additional Reference(s): DWR Levee Log, 2002 (HLM 22.46), listed as a 24-inch corrugated metal pipe (CMP). USACE San Joaquin O&M Manual, Unit 601 Part 1 (SJR601.1), 1967, Revised 25 May 2011, (HLM 22.46), listed as a 24-inch CMP] FS Date: 4/23/2014 | | | | | | |

Headwall, pipe, and flapgate visible on WS toe.

Headwall and pipe visible on LS toe.

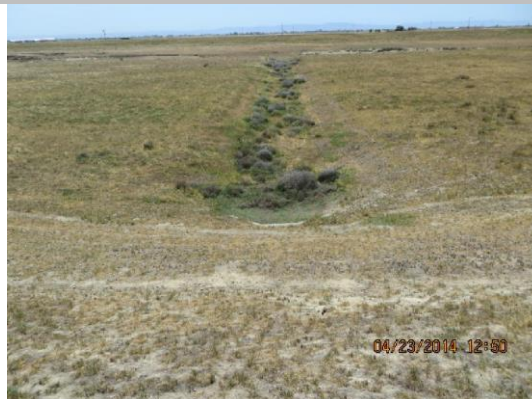
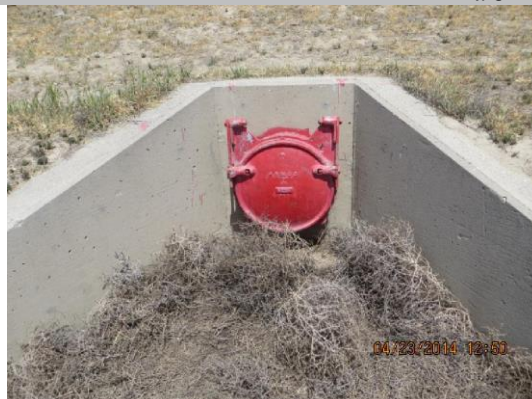
| DS_ID:19791 FS_ID:62482 EP_NO: N/A Repair Type: Non-Urgent EVAL Issue: Crossing Status: Found UCIP Comments: 04/23/2014 Dense vegetation limits the inspector's visibility to identify signs of pipe failure (leaks) along the landward slope. Recommend removing vegetation along pipe alignment to conduct proper inspection of structure. Sediment buildup in pipe visible from landward side--recommend contacting owner to clear pipe. (W. Wylie - DWR UCIP) FIELD_STRUCT_DESC: 24-inch corrugated metal gravity drainage pipe through the levee, 12.2 feet below the crown. Flap gate on the waterside (WS) end. Concrete headwall on the landside (LS) end. Concrete U-shaped headwall on the WS end. [Additional Reference(s): DWR Levee Log, 2002 (HLM 22.79), listed as a 24-inch corrugated metal pipe (CMP). USACE San Joaquin O&M Manual, Unit 601 Part 1 (SJR601.1), 1967, Revised 25 May 2011, (HLM 22.79), listed as a 24-inch CMP] FS Date: 4/23/2014 | | | | | |

Headwall, pipe, and flapgate visible on WS toe.

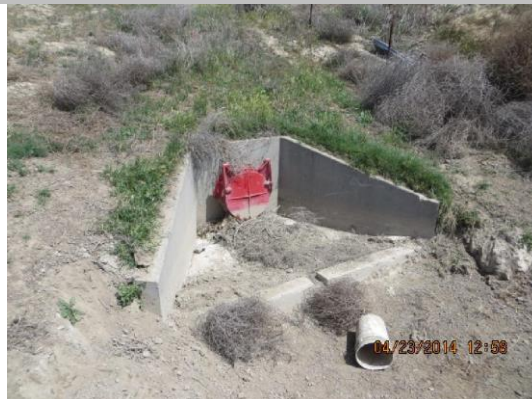
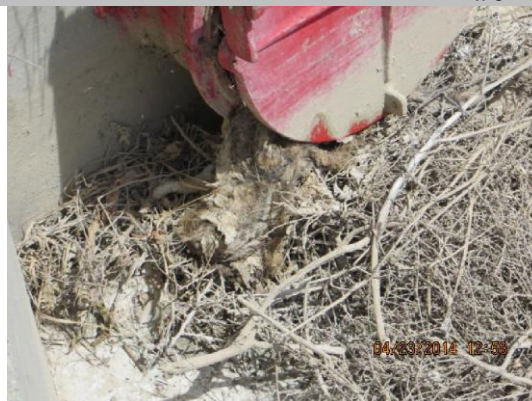
DS_ID:19793
FS_ID:62484
EP_NO: N/A
Repair Type: Non-Urgent
EVAL Issue:
Crossing Status: Found
UCIP Comments: 04/23/2014 Debris blocking closure of outlet. Dense vegetation limits the inspector's visibility to identify signs of pipe failure (leaks) along the waterward and landward slopes. Recommend removing vegetation along pipe alignment to conduct proper inspection of structure. (W. Wylie - DWR UCIP)
FIELD_STRUCT_DESC: 24-inch corrugated metal gravity drainage pipe through the levee, 11.5 feet below the crown. Flap gate on the waterside (WS) end. Concrete headwall on the landside (LS) end. Concrete U-shaped headwall on the WS end. [Additional Reference(s): DWR Levee Log, 2002 (HLM 23.06), listed as a 24-inch corrugated metal pipe (CMP)]
FS Date: 4/23/2014

Debris blocking closure of outlet on WS toe.
