Flood Control Project Maintenance Levee Inspections

Fall 2020 Levee Maintenance Deficiency Summary Report

San Joaquin River Basin

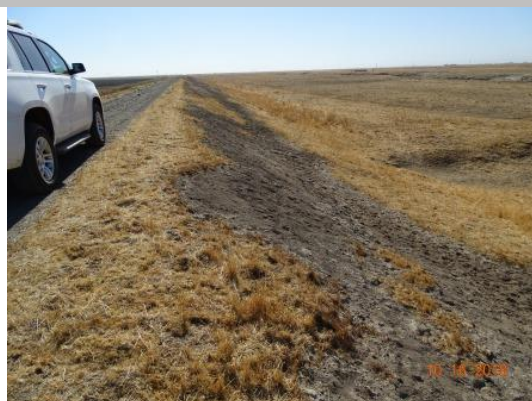
Photo 1 of 1 : FA_2020_NA0010_123_160_20200901_00028.jpg

| There is slope damage caused by livestock on waterside. | | | | | |

Slope damage cause by livestock foot traffic. (Fall 2018)

| A2 : Repair the levee slope damaged by livestock and prevent large animal access. | | | | | |

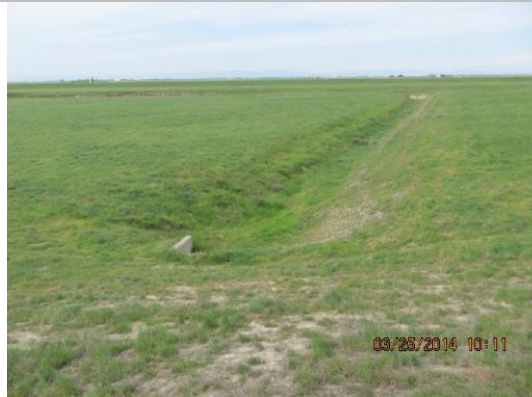
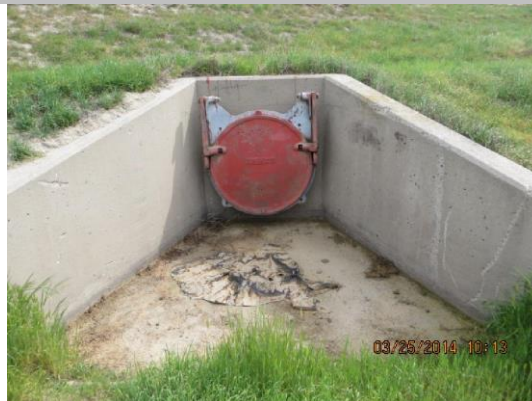
DS_ID:19797
 FS_ID:62489
 EP_NO: N/A
 Repair Type: Non-Urgent
 EVAL Issue:
 Crossing Status: Found
 UCIP Comments: 03/25/2014 Minor sediment/debris buildup in pipe visible from landward side--recommend contacting owner to clear pipe. (W. Wylie - DWR UCIP)
 FIELD_STRUCT_DESC: 36-inch corrugated metal gravity drainage pipe through the levee, 12.1 feet below the crown. Flap gate on the waterside (WS) end. Concrete headwall on the landside (LS) end. Concrete U-shaped headwall on the WS end. [Additional Reference(s): DWR Levee Log, 2002 (HLM 23.92), listed as a 36-inch corrugated metal pipe (CMP). USACE San Joaquin O&M Manual, Unit 601 Part 1 (SJR601.1), 1967, Revised 25 May 2011, (HLM 23.85), listed as a 36-inch CMP]
 FS Date: 3/25/2014

Concrete headwall on WS toe.

Flapgate at Concrete headwall on WS toe.

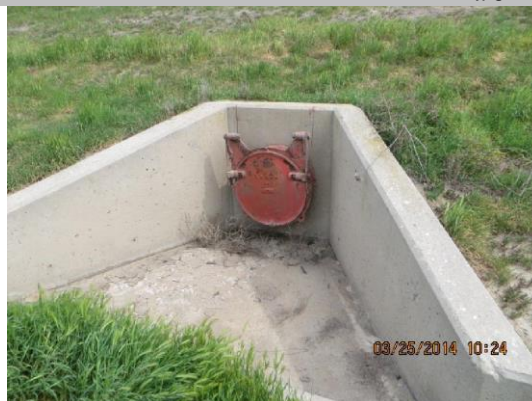
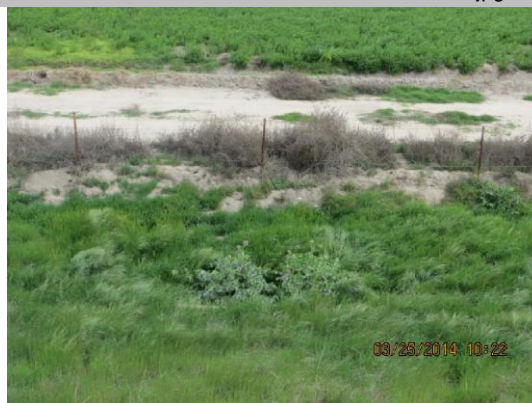
DS_ID:19798
 FS_ID:62490
 EP_NO: N/A
 Repair Type: Non-Urgent
 EVAL Issue:
 Crossing Status: Found
 UCIP Comments: 03/25/2014 Dense vegetation limits the inspector's visibility to identify signs of pipe failure (leaks) along the landward slope. Recommend removing vegetation along pipe alignment to conduct proper inspection of structure. (W. Wylie - DWR UCIP)
 FIELD_STRUCT_DESC: 24-inch corrugated metal gravity drainage pipe through the levee, 11.2 feet below the crown. Flap gate on the waterside (WS) end. Concrete headwall on the landside (LS) end. Concrete U-shaped headwall on the WS end. [Additional Reference(s): DWR Levee Log, 2002 (HLM 24.18), listed as a 24-inch corrugated metal pipe (CMP). USACE San Joaquin O&M Manual, Unit 601 Part 1 (SJR601.1), 1967, Revised 25 May 2011, (HLM 24.18), listed as a 24-inch CMP]
 FS Date: 3/25/2014

Flapgate at concrete headwall at WS toe.

Concrete headwall at LS toe.

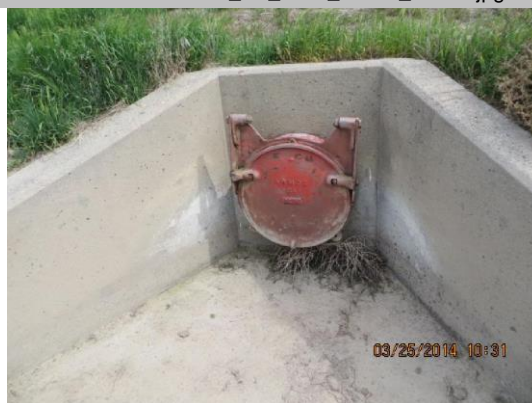
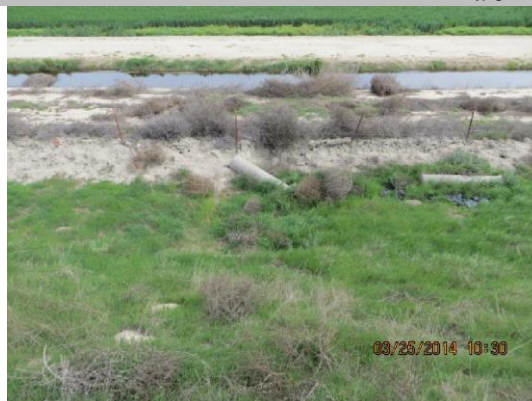
DS_ID:19799
FS_ID:62491
EP_NO: N/A
Repair Type: Non-Urgent
EVAL Issue:
Crossing Status: Found
UCIP Comments: 03/25/2014 Dense vegetation limits the inspector's visibility to identify signs of pipe failure (leaks) along the landward slope. Recommend removing vegetation along pipe alignment to conduct proper inspection of structure. (W. Wylie - DWR UCIP)
FIELD_STRUCT_DESC: 24-inch corrugated metal gravity drainage pipe through the levee, 11.2 feet below the crown. Flap gate on the waterside (WS) end. Concrete headwall on the landside (LS) end. Concrete U-shaped headwall on the WS end. [Additional Reference(s): DWR Levee Log, 2002 (HLM 24.46), listed as a 24-inch corrugated metal pipe (CMP). USACE San Joaquin O&M Manual, Unit 601 Part 1 (SJR601.1), 1967, Revised 25 May 2011, (HLM 24.46), listed as a 24-inch CMP]
FS Date: 3/25/2014

Concrete headwall on WS toe.

Flapgate at Concrete headwall on WS toe.

Concrete headwall on LS toe.

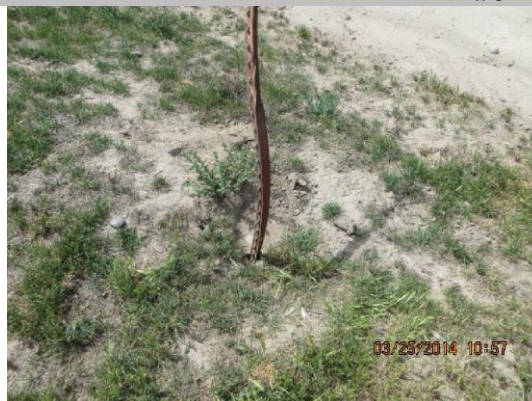
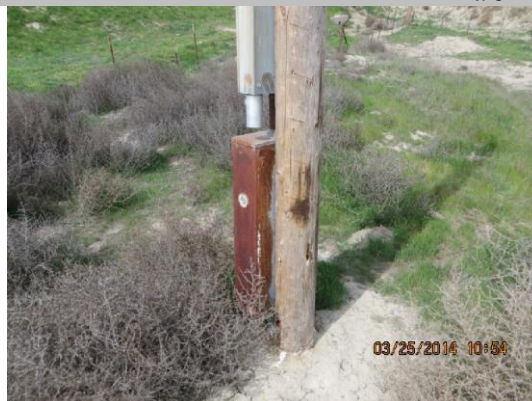
| DS_ID:19802 FS_ID:62494 EP_NO: 12873 Repair Type: Non-Urgent EVAL Issue: Crossing Status: Found UCIP Comments: 03/25/2014 Clear soil from siphon breaker and install a protective riser. (W. Wylie - DWR UCIP) FIELD_STRUCT_DESC: 16-inch coated steel irrigation discharge pipe through the levee, 2 feet below the crown. Slant pump at the channel on the waterside (WS) toe. Siphon breaker on the WS shoulder. Gate valve on the landside (LS) toe. A preexisting ditch runs from the WS toe to the channel. Riprap placed around the intake. 2-inch polyvinyl chloride (PVC) electrical conduit at the same location. (Plans to install a pump with a discharge pipe through the levee authorized under Permit No. 12873, 1980 - Bowles Farming Company). [Additional Reference(s): DWR Levee Log, 2002 (HLM 24.88), listed as a 16-inch pipe] FS Date: 3/25/2014 | | | | | | |

Slant pump at channel on WS toe.

Buried Siphon breaker on WS shoulder.

Power pole, meter, and electrical panel off LS toe.

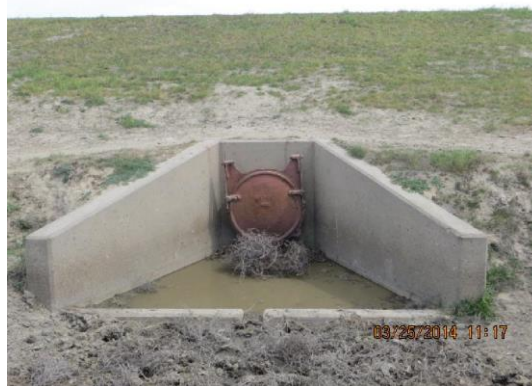
Photo 2 of 3 : UCIP_FA_2020_62496_59317.jpg

Flapgate on concrete headwall at WS toe.

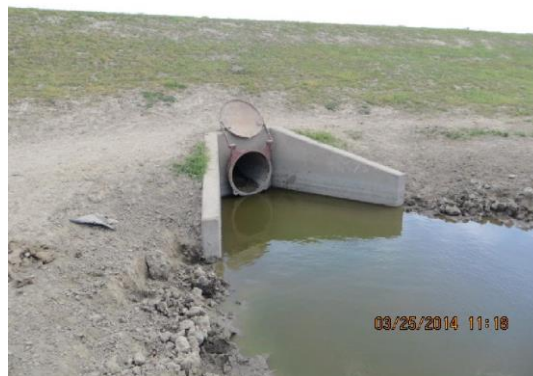
Photo 1 of 3 : UCIP_FA_2020_62497_59321.jpg

| DS_ID:19805 FS_ID:62497 EP_NO: N/A Repair Type: Non-Urgent EVAL Issue: Crossing Status: Found UCIP Comments: 03/25/2014 Sediment buildup in pipe visible from landward side--recommend contacting owner to clear pipe. (W. Wylie - DWR UCIP) FIELD_STRUCT_DESC: 30-inch corrugated metal gravity drainage pipe through the levee, 12.1 feet below the crown. Flap gate on the waterside (WS) end. Concrete headwall on the landside (LS) end. Concrete U-shaped headwall on the WS end. [Additional Reference(s): DWR Levee Log, 2002 (HLM 25.53), listed as a 30-inch corrugated metal pipe (CMP). USACE San Joaquin O&M Manual, Unit 601 Part 1 (SJR601.1), 1967, Revised 25 May 2011, (HLM 25.53), listed as a 30-inch CMP] FS Date: 3/25/2014 | | | | | | |

Flapgate on headwall at WS toe.

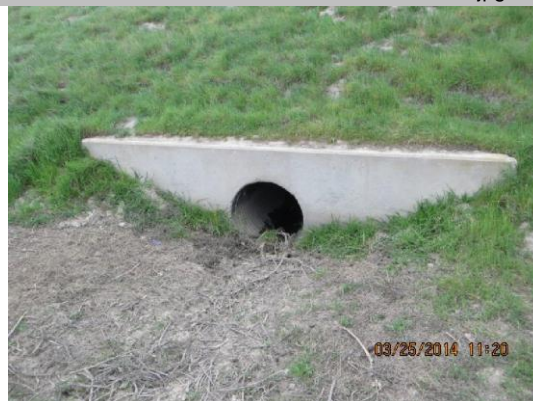
Photo 2 of 3 : UCIP_FA_2020_62497_59320.jpg

Concrete headwall on LS toe.

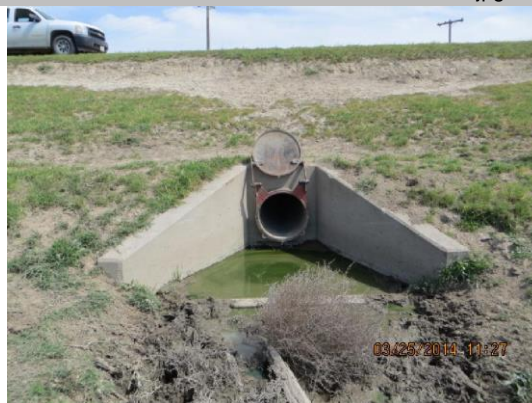
Photo 2 of 3 : UCIP_FA_2020_62498_59340.jpg

Flapgate on Concrete headwall at WS toe.

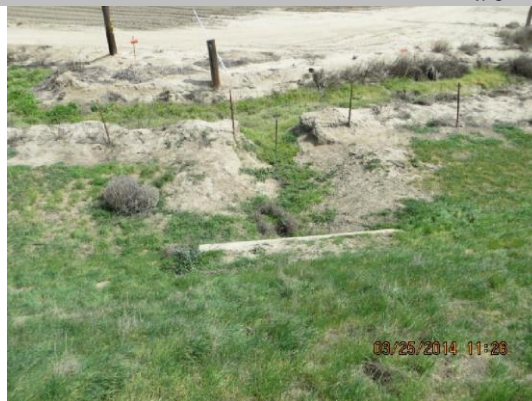
Photo 3 of 3 : UCIP_FA_2020_62498_59342.jpg

Concrete headwall on LS toe.

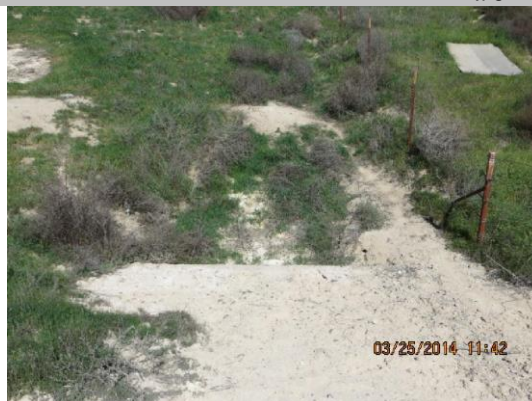
Photo 1 of 3 : UCIP_FA_2020_62500_59350.jpg

DS_ID:19808
 FS_ID:62500
 EP_NO: N/A
 Repair Type: Non-Urgent
 EVAL Issue:
 Crossing Status: Found
 UCIP Comments: 03/25/2014 Pipe has heavy silt buildup visible from landward side--recommend contacting owner to clear pipe. (W. Wylie - DWR UCIP)
 FIELD_STRUCT_DESC: 24-inch corrugated metal gravity drainage pipe through the levee, 11.4 feet below the crown. Flap gate on the waterside (WS) end. Concrete headwall on the landside (LS) end. Concrete U-shaped headwall on the WS end. [Additional Reference(s): DWR Levee Log, 2002 (HLM 26.85), listed as a 24-inch corrugated metal pipe (CMP). USACE San Joaquin O&M Manual, Unit 601 Part 1 (SJR601.1), 1967, Revised 25 May 2011, (HLM 26.85), listed as a 24-inch CMP]
 FS Date: 3/25/2014

Concrete headwall on LS toe.

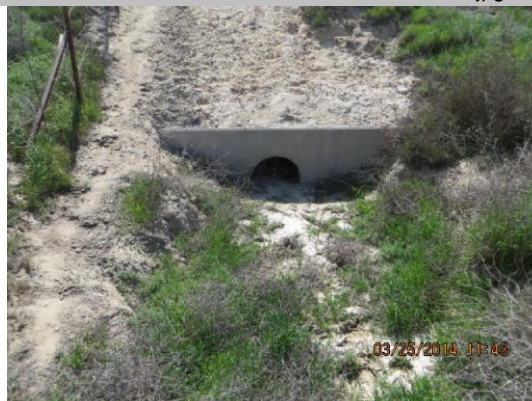
Photo 2 of 3 : UCIP_FA_2020_62500_59349.jpg

Concrete headwall on LS toe.

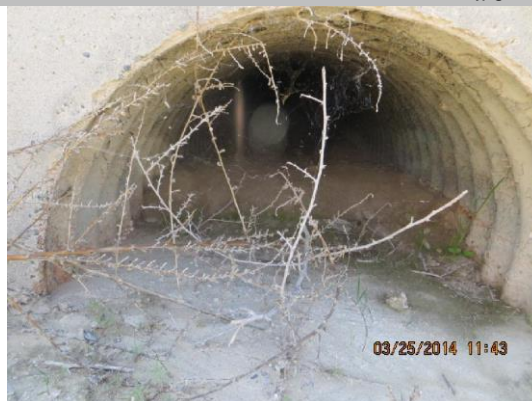
Photo 3 of 3 : UCIP_FA_2020_62500_59348.jpg

Silt buildup in pipe at LS toe.

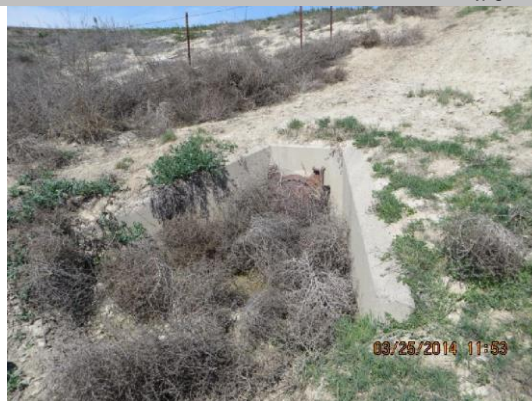
Photo 2 of 3 : UCIP_FA_2020_62501_59355.jpg

Flapgate and Concrete headwall at WS toe.

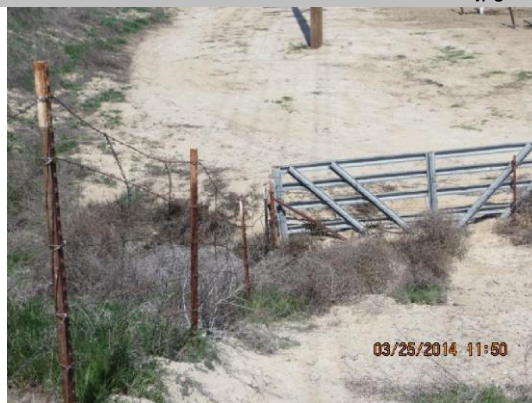
Photo 3 of 3 : UCIP_FA_2020_62501_59354.jpg

Concrete headwall at LS toe.

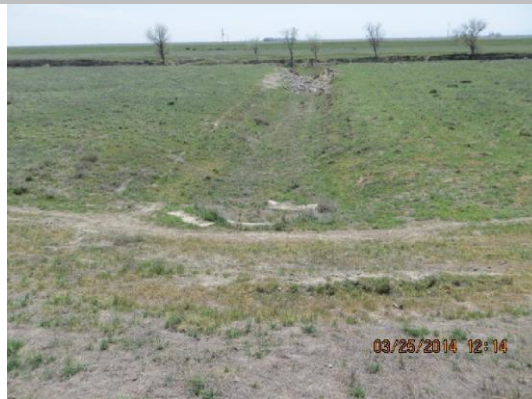
Photo 1 of 3 : UCIP_FA_2020_62503_59382.jpg

| DS_ID:19750 FS_ID:62503 EP_NO: N/A Repair Type: Non-Urgent EVAL Issue: Crossing Status: Found UCIP Comments: 03/25/2014 Animal Burrowing activity at LS toe may undermine headwall. (W. Wylie - DWR UCIP) FIELD_STRUCT_DESC: 24-inch corrugated metal gravity drainage pipe through the levee, 10.8 feet below the crown. Flap gate on the waterside (WS) end. Concrete headwall on the landside (LS) end. Concrete U-shaped headwall on the WS end. [Additional Reference(s): DWR Levee Log, 2002 (HLM 28.17), listed as a 24-inch corrugated metal pipe (CMP). USACE San Joaquin O&M Manual, Unit 601 Part 1 (SJR601.1), 1967, Revised 25 May 2011, (HLM 28.17), listed as a 24-inch CMP] FS Date: 3/25/2014 | | | | | | |

Concrete headwall on WS toe.

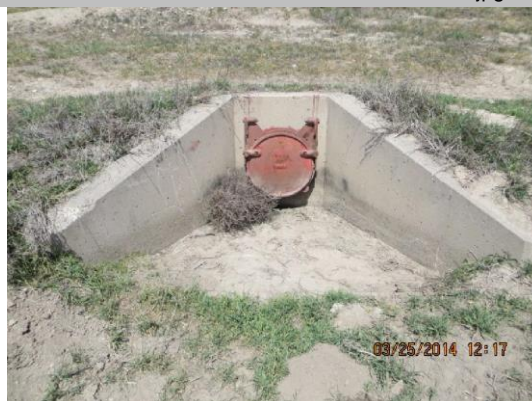
Photo 2 of 3 : UCIP_FA_2020_62503_59383.jpg

Flapgate on Concrete headwall at WS toe.

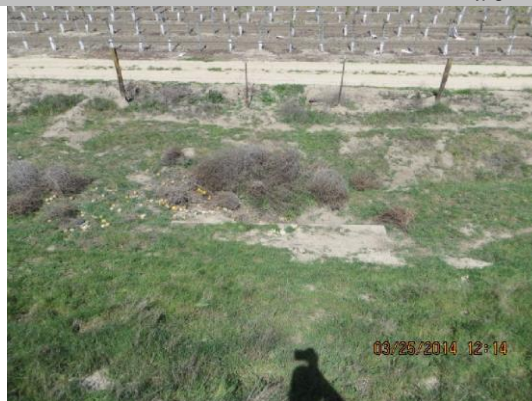
Photo 3 of 3 : UCIP_FA_2020_62503_59381.jpg

Concrete headwall on LS toe.

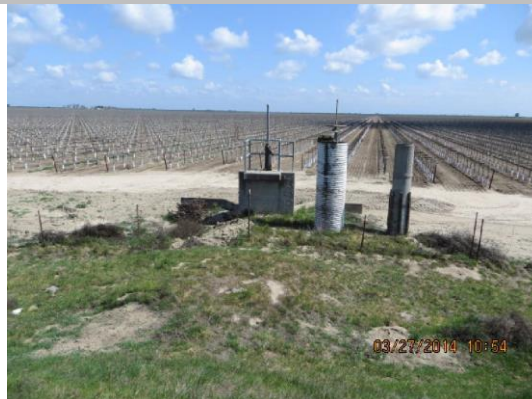
Photo 1 of 3 : UCIP_FA_2020_62505_59410.jpg

| DS_ID:19752 FS_ID:62505 EP_NO: N/A Repair Type: Non-Urgent EVAL Issue: Crossing Status: Found UCIP Comments: 7/20/2016 same as previous inspection. Crossing has been downgraded from Urgent to Non-Urgent slide gate is on LS. Pipe is buried through WS. Need to coordinate with owner to determine permit used to authorized sleeved pipe. (O. Magana - DWR UCIP)3/27/2014 Slide gate will not close due to 24-inch PVC pipe sleeved through pipe. Also slide gate rails rusted beyond use. (W. Wylie - DWR UCIP) FIELD_STRUCT_DESC: [Rodunder Siphon Structure] 48-inch reinforced concrete irrigation siphon pipe through the levee, 12.1 feet below the crown. Concrete U-shaped headwall on inlet structure on the landside (LS) end. Slide gate mounted on concrete headwall on the LS. 36-inch corrugated metal pipe (CMP) riser with a slide gate on the LS, 8 feet upstream from the siphon. 24-inch pipe from this unit enters the siphon behind the inlet structure. [Additional Reference(s): DWR Levee Log, 2002 (HLM 28.95), listed as a 48-inch reinforced concrete pipe (RCP). USACE San Joaquin O&M Manual, Unit 601 Part 1 (SJR601.1), 1967, Revised 25 May 2011, (HLM 28.95), listed as a 48-inch RCP referenced as Rodunder Siphon] FS Date: 7/20/2016 | | | | | | |

Slide gate mounted to concrete headwall on LS toe.

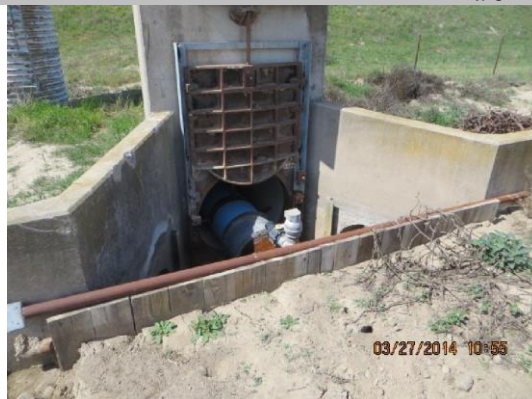
Photo 2 of 3 : UCIP_FA_2020_62505_59409.jpg

24-inch PVC pipe sleeved through 48-inch concrete pipe.

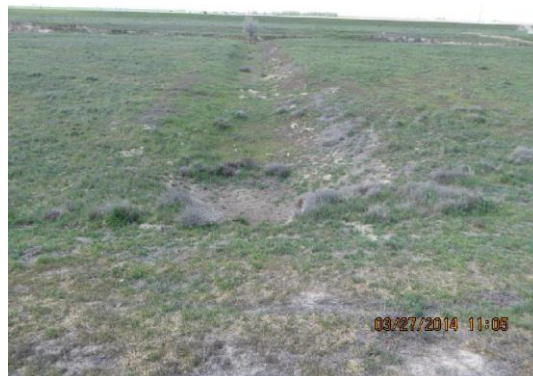
Photo 1 of 3 : UCIP_FA_2020_62510_59414.jpg

DS_ID:19753
FS_ID:62510
EP_NO: N/A
Repair Type: Non-Urgent
EVAL Issue:
Crossing Status: Found
UCIP Comments: 03/27/2014 Dense vegetation limits the inspector's visibility to identify signs of pipe failure (leaks) along the landward slope. Recommend removing vegetation along pipe alignment to conduct proper inspection of structure. Sediment buildup in pipe visible from landward side--recommend contacting owner to clear pipe. (W. Wylie - DWR UCIP)
FIELD_STRUCT_DESC: 36-inch corrugated metal gravity drainage pipe through the levee, 10.2 feet below the crown. Flap gate on the waterside (WS) end. Concrete headwall on the landside (LS) end. Concrete U-shaped headwall on the WS end. [Additional Reference(s): DWR Levee Log, 2002 (HLM 29.49), listed as a 36-inch corrugated metal pipe (CMP). USACE San Joaquin O&M Manual, Unit 601 Part 1 (SJR601.1), 1967, Revised 25 May 2011, (HLM 29.49), listed as a 36-inch CMP]

Concrete headwall on WS toe.

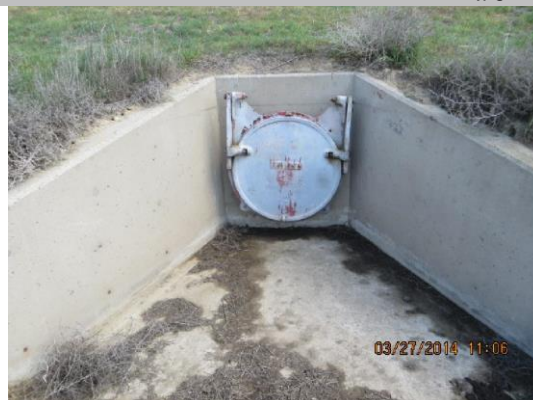
Photo 2 of 3 : UCIP_FA_2020_62510_59413.jpg

Flapgate on Concrete headwall at WS toe.

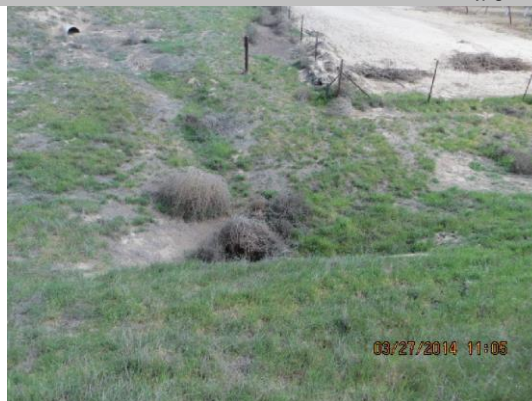
Photo 3 of 3 : UCIP_FA_2020_62510_59415.jpg

Concrete headwall on LS toe.

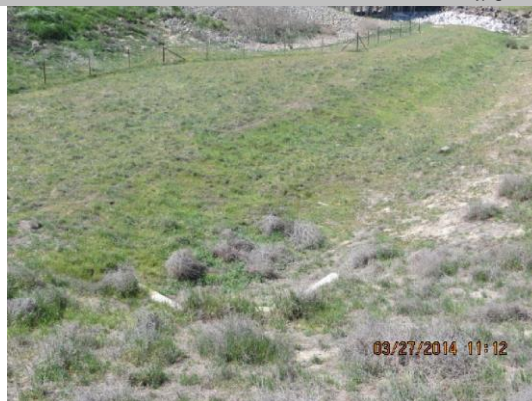
Photo 1 of 3 : UCIP_FA_2020_62511_59424.jpg

DS_ID:19754
 FS_ID:62511
 EP_NO: N/A
 Repair Type: Non-Urgent
 EVAL Issue:
 Crossing Status: Found
 UCIP Comments: 03/27/2014 Dense vegetation limits the inspector's visibility to identify signs of pipe failure (leaks) along the landward slope. Recommend removing vegetation along pipe alignment to conduct proper inspection of structure. (W. Wylie - DWR UCIP)
 FIELD_STRUCT_DESC: 30-inch by 30-inch reinforced concrete box gravity drainage culvert through the levee, 12 feet below the crown. Flap gate on the waterside (WS) end. Concrete headwall on the landside (LS) end. Concrete U-shaped headwall on the WS end.
 [Additional Reference(s): DWR Levee Log, 2002 (HLM 29.72), listed as a 30-inch square reinforced concrete box culvert (RCBC). USACE San Joaquin O&M Manual, Unit 601 Part 1 (SJR601.1), 1967, Revised 25 May 2011, (HLM 29.72), listed as a 2.5-feet by 2.5-feet RCBC]
 FS Date: 3/27/2014

Concrete headwall on WS toe.

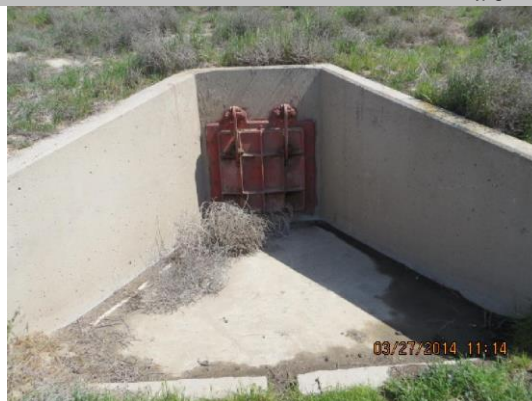
Photo 2 of 3 : UCIP_FA_2020_62511_59426.jpg

Flapgate on Concrete headwall at WS toe.

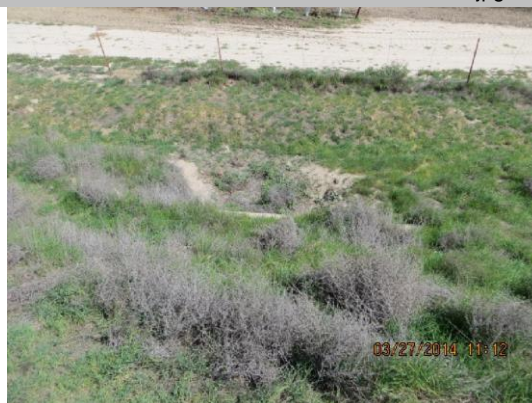
Photo 3 of 3 : UCIP_FA_2020_62511_59425.jpg

Concrete headwall on LS toe.

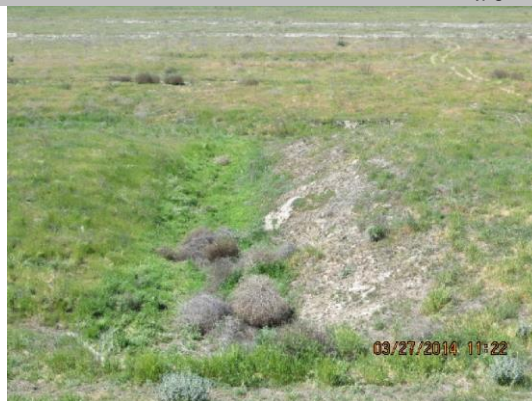
Photo 1 of 3 : UCIP_FA_2020_62512_59430.jpg

DS_ID:19696
FS_ID:62512
EP_NO: N/A
Repair Type: Non-Urgent
EVAL Issue:
Crossing Status: Found
UCIP Comments: 03/27/2014 Dense vegetation limits the inspector's visibility to identify signs of pipe failure (leaks) along the landward slope. Recommend removing vegetation along pipe alignment to conduct proper inspection of structure. (W. Wylie - DWR UCIP)
FIELD_STRUCT_DESC: 30-inch by 30-inch reinforced concrete box gravity drainage culvert through the levee, 13.1 feet below the crown. Flap gate on the waterside (WS) end. Concrete headwall on the landside (LS) end. Concrete U-shaped headwall on the WS end.
[Additional Reference(s): DWR Levee Log, 2002 (HLM 30.04), listed as a 30-inch square reinforced concrete box culvert (RCBC). USACE San Joaquin O&M Manual, Unit 601 Part 1 (SJR601.1), 1967, Revised 25 May 2011, (HLM 30.04), listed as a 2.5-feet by 2.5-feet RCBC]
FS Date: 3/27/2014

Concrete headwall on WS toe.

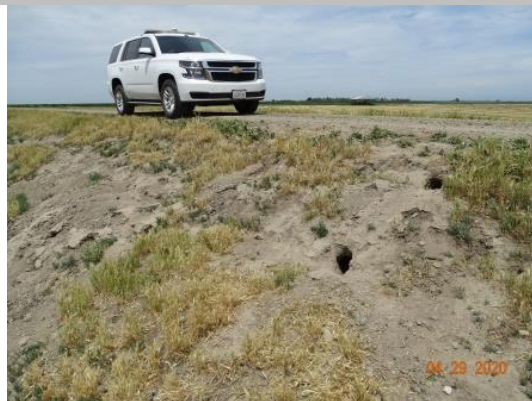
Photo 1 of 1 : FA_2020_NA0010_123_230_20200901_00038.jpg

| Several rodent burrows in the waterside slope and shoulder. | | | | | |

Rodent burrows in the waterside slope. (Spring 2020)

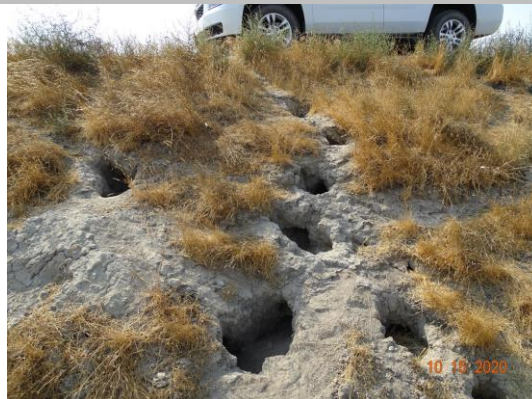
Photo 1 of 1 : FA_2020_NA0010_123_129_20201028_00324.jpg

Several large rodent holes noted at this location. (Fall 2020)

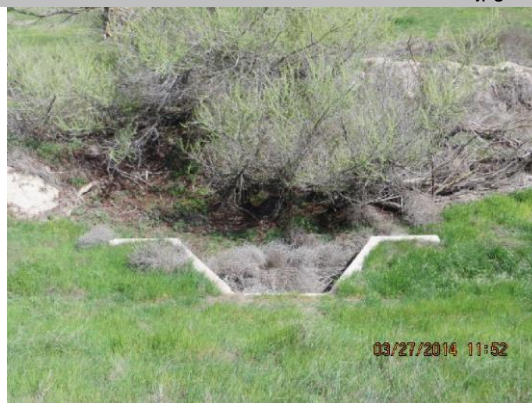
Photo 3 of 3 : UCIP_FA_2020_62515_59443.jpg

Concrete headwall on LS toe. Note tumbleweeds blocking inlet.

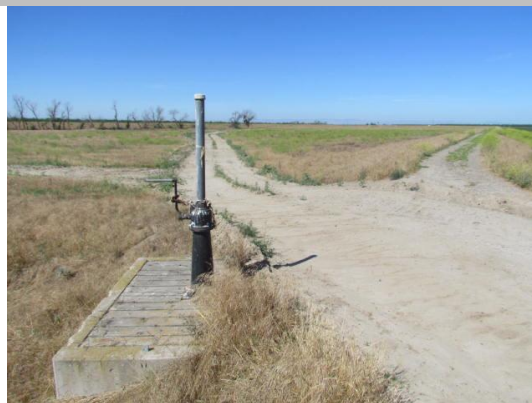
Photo 1 of 1 : FA_2020_NA0010_123_11_20200901_00005.jpg

| There is an unauthorized ramp on waterside slope. Landowner cut unauthorized ramp on waterside slope and levee crown. | | | | | |

Looking west at ramp on waterward slope.

| C2 : Repair depressions or ruts in the crown or slope. | | | | | |

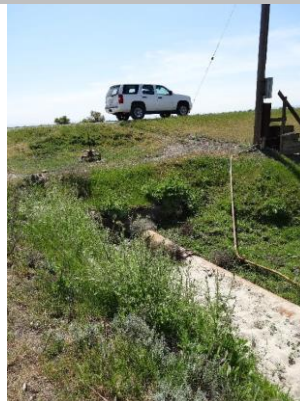
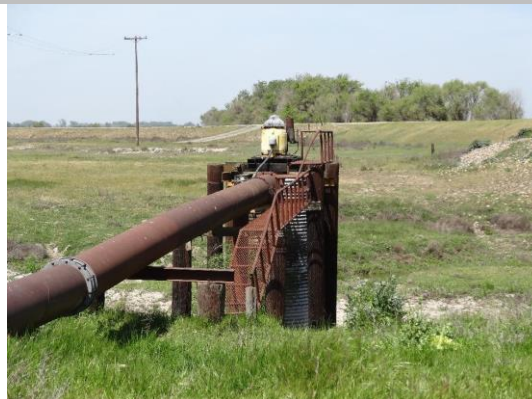
DS_ID:19815
FS_ID:62229
EP_NO: N/A
Repair Type: Non-Urgent
EVAL Issue:
Crossing Status: Found
UCIP Comments: 04/18/2014 Need to contact owner. Sediment buildup on landward side. Recommend removing sediment buildup on landward toe. (O. Magana - DWR UCIP)
FIELD_STRUCT_DESC: 24-inch corrugated metal irrigation discharge pipe through the levee, 7.2 feet below the crown. Pump on concrete structure in the channel. Slide gate in a 36-inch corrugated metal pipe (CMP) riser on the waterside (WS) slope. Concrete headwall on each end. [Additional Reference(s): DWR Levee Log, 2002 (HLM 0.74), listed as a 24-inch corrugated metal pipe (CMP). USACE San Joaquin O&M Manual, Unit 601 Part 1 (SRJ601.1), 1967, Revised 25 May 2011, (HLM 0.74), listed as a 24-inch CMP]
FS Date: 4/18/2014

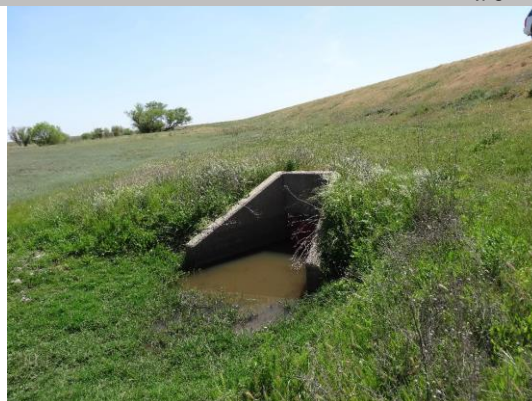
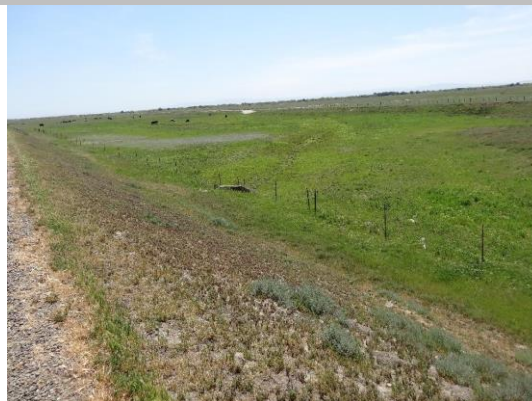
DS_ID:19816
 FS_ID:62230
 EP_NO: N/A
 Repair Type: Non-Urgent
 EVAL Issue:
 Crossing Status: Found
 UCIP Comments: 04/18/2014 Landward side blocked--need to contact owner to determine status of crossing. (O. Magana - DWR UCIP)
 FIELD_STRUCT_DESC: 24-inch corrugated metal gravity drainage pipe through the levee, 16.2 feet below the crown. Flap gate on the waterside (WS) end. Concrete U-shaped headwall on each end.
 [Additional Reference(s): DWR Levee Log, 2002 (HLM 0.86), listed as a 24-inch corrugated metal pipe (CMP). USACE San Joaquin O&M Manual, Unit 601 Part 1 (SRJ601.1), 1967, Revised 25 May 2011, (HLM 0.86), listed as a 24-inch CMP]
 FS Date: 4/18/2014

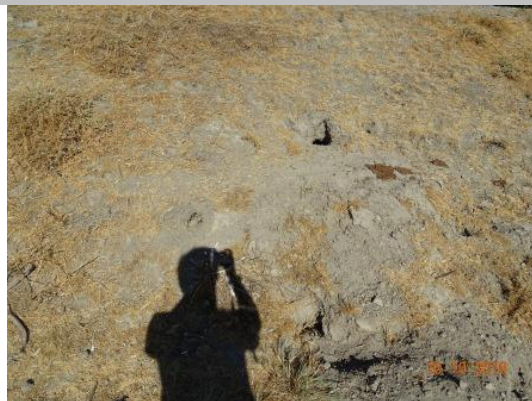
Photo 1 of 1 : FA_2020_NA0010_124_93_20200901_00026.jpg

| Several rodent burrows including large burrows were observed at this location. | | | | | |

View of landside slope. (Fall 2018)

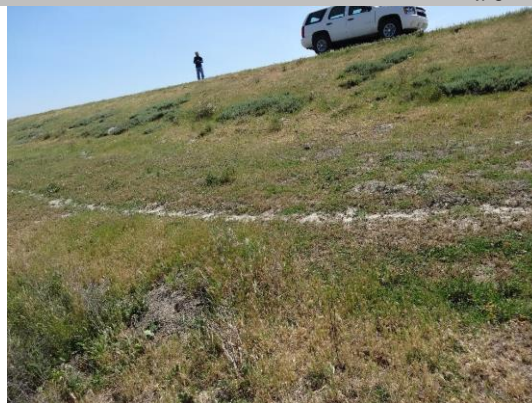
| DS_ID:19817 FS_ID:62231 EP_NO: N/A Repair Type: Non-Urgent EVAL Issue: Crossing Status: Found UCIP Comments: 04/18/2014 No access was available to landward side due to fence. Recommend removing some of the vegetation on waterward toe. (O. Magana - DWR UCIP) FIELD_STRUCT_DESC: 24-inch corrugated metal gravity drainage pipe through the levee, 13.5 feet below the crown. Flap gate on the waterside (WS) end. Concrete headwall on each end. [Additional Reference(s): DWR Levee Log, 2002 (HLM 1.96), listed as a 24-inch corrugated metal pipe (CMP). USACE San Joaquin O&M Manual, Unit 601 Part 1 (SRJ601.1), 1967, Revised 25 May 2011, (HLM 1.95), listed as a 24-inch CMP] FS Date: 4/18/2014 | | | | | | |

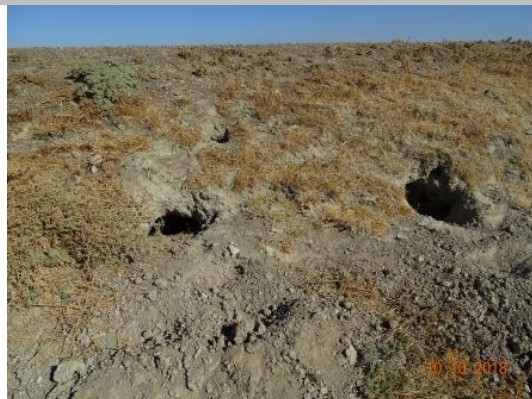
Photo 1 of 1 : FA_2020_NA0010_124_92_20200901_00025.jpg

View of large rodent holes in landside slope. (Fall 2018)

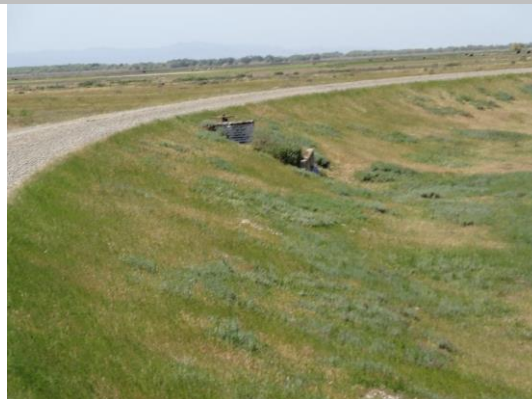
Photo 1 of 3 : UCIP_FA_2020_62242_66354.jpg

View of waterward side.

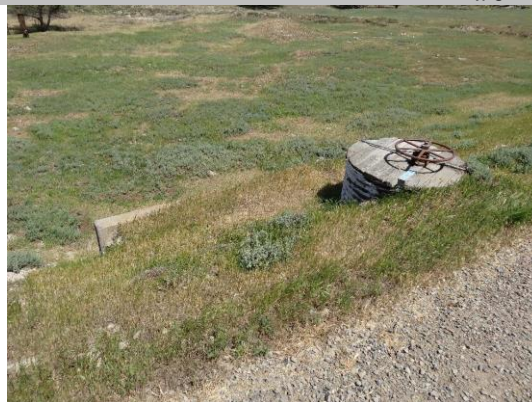
Photo 2 of 3 : UCIP_FA_2020_62242_66357.jpg

View of waterward side.

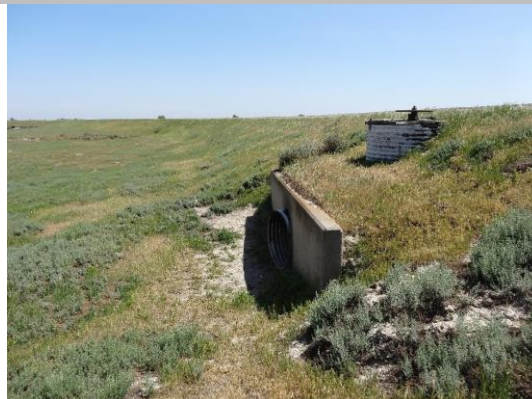
Photo 3 of 3 : UCIP_FA_2020_62242_66356.jpg

CMP riser, concrete headwall, and pipe visible on waterward side.

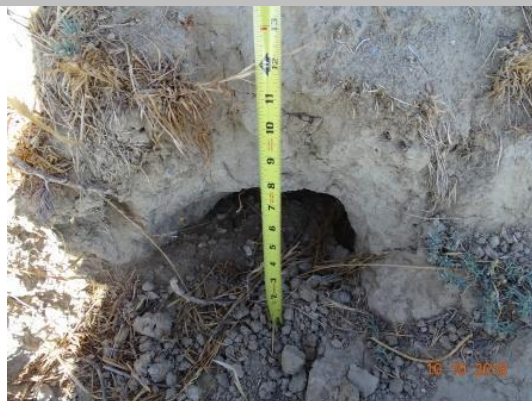
Photo 1 of 1 : FA_2020_NA0010_124_76_20200901_00013.jpg

| There are several rodent burrows in the landside slope at this location. | | | | | |

Representative view of rodent burrow found at this section. (Fall 2018)

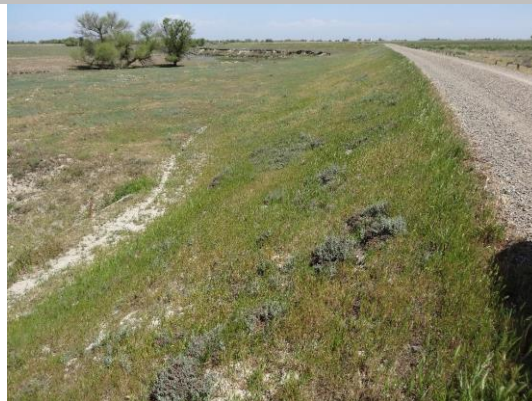
Photo 2 of 3 : UCIP_FA_2020_62233_66360.jpg

View of waterward side.

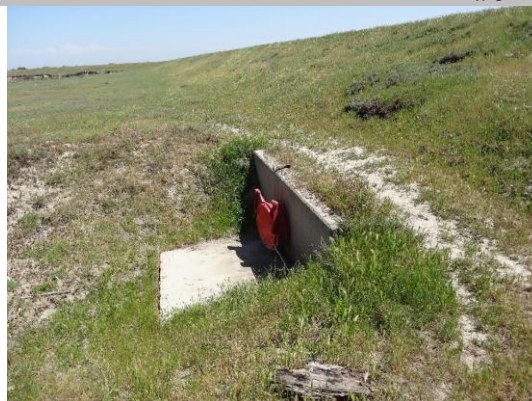
Photo 3 of 3 : UCIP_FA_2020_62233_66359.jpg

View of concrete headwall, flap gate, and concrete apron located on waterward side.

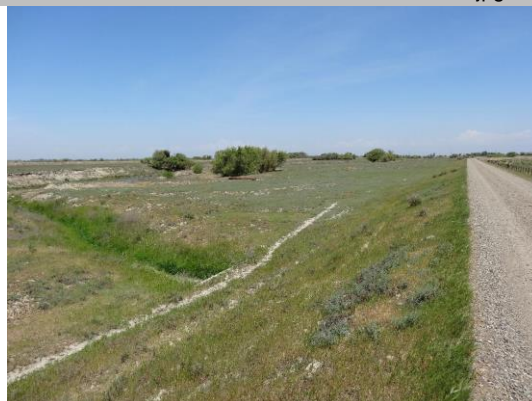
Photo 1 of 3 : UCIP_FA_2020_62234_66369.jpg

DS_ID:19820
 FS_ID:62234
 EP_NO: N/A
 Repair Type: Non-Urgent
 EVAL Issue:
 Crossing Status: Found
 UCIP Comments: 04/18/2014 Dense vegetation limits the inspector's visibility to identify signs of pipe condition on landward toe--headwall blocked by dense vegetation. Recommend removing vegetation from landward toe. (O. Magana - DWR UCIP)
 FIELD_STRUCT_DESC: 24-inch corrugated metal gravity drainage pipe through the levee, 10.5 feet below the crown. Flap gate on the waterside (WS) end. Concrete headwall on each end. [Additional Reference(s): DWR Levee Log, 2002 (HLM 2.85), listed as a 24-inch corrugated metal pipe (CMP). USACE San Joaquin O&M Manual, Unit 601 Part 1 (SRJ601.1), 1967, Revised 25 May 2011, (HLM 2.85), listed as a 24-inch CMP]
 FS Date: 4/18/2014

View of waterward side.

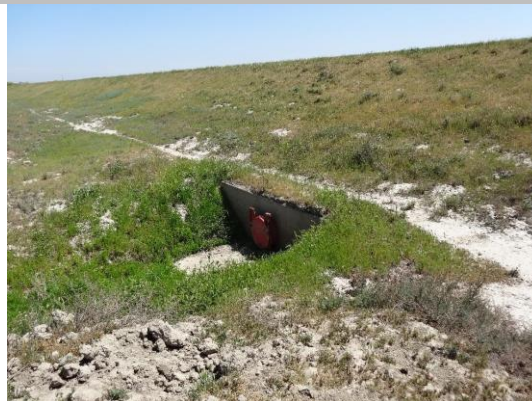
Photo 2 of 3 : UCIP_FA_2020_62236_66380.jpg

Flap gate and concrete headwall visible on waterward side.

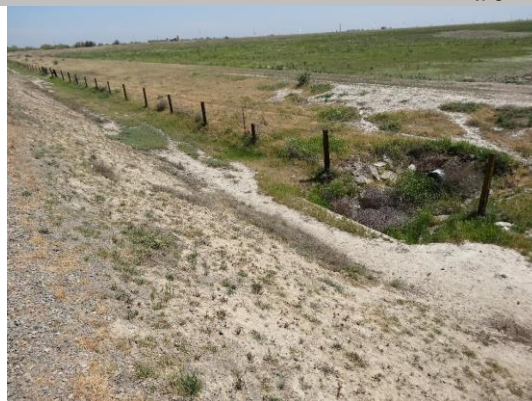
Photo 3 of 3 : UCIP_FA_2020_62236_66383.jpg

View of landward side.

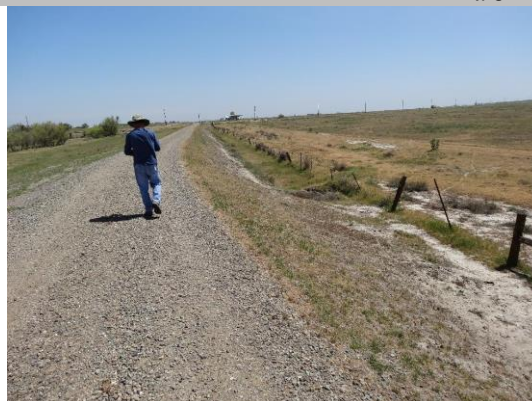
Photo 1 of 3 : UCIP_FA_2020_62237_66384.jpg

DS_ID:19822
 FS_ID:62237
 EP_NO: N/A
 Repair Type: Non-Urgent
 EVAL Issue:
 Crossing Status: Found
 UCIP Comments: 04/18/2014 Dense vegetation limits the inspector's visibility to identify signs of pipe condition on waterward slope and landward toe (headwall blocked by dense vegetation). Recommend removing vegetation from landward toe. (O. Magana - DWR UCIP)
 FIELD_STRUCT_DESC: 24-inch corrugated metal gravity drainage pipe through the levee, 10.4 feet below the crown. Flap gate on the waterside (WS) end. Concrete headwall on each end. [Additional Reference(s): DWR Levee Log, 2002 (HLM 3.29), listed as a 24-inch corrugated metal pipe (CMP). USACE San Joaquin O&M Manual, Unit 601 Part 1 (SRJ601.1), 1967, Revised 25 May 2011, (HLM 3.29), listed as a 24-inch CMP]
 FS Date: 4/18/2014

Overview of levee crown and landward side.

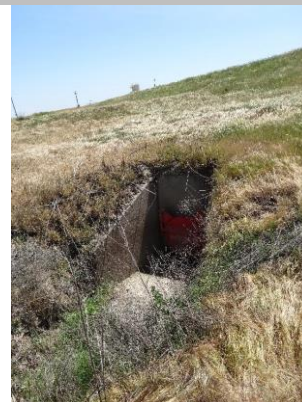
Photo 2 of 3 : UCIP_FA_2020_62243_66390.jpg

Flap gate and concrete headwall visible on waterward side.

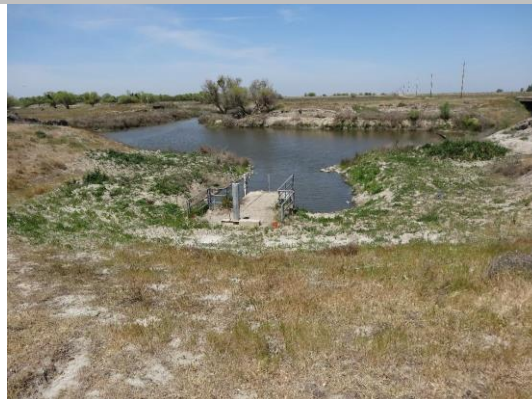
Photo 2 of 3 : UCIP_FA_2020_62240_71644.jpg

View of waterward side.

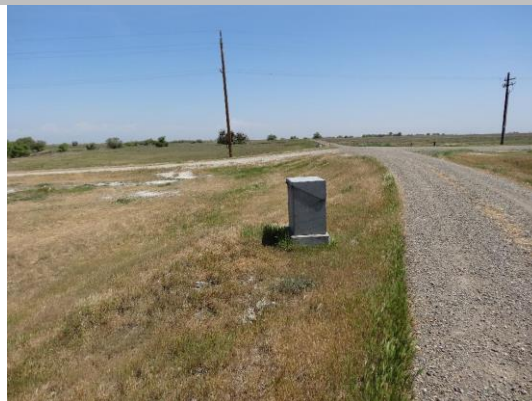
Photo 3 of 3 : UCIP_FA_2020_62240_71642.jpg

Metal box located on waterward shoulder.

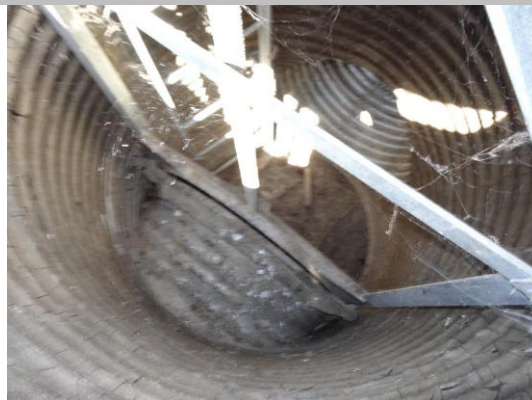
Photo 2 of 3 : UCIP_FA_2020_62241_66395.jpg

Inside view of cmp riser located on waterward slope.

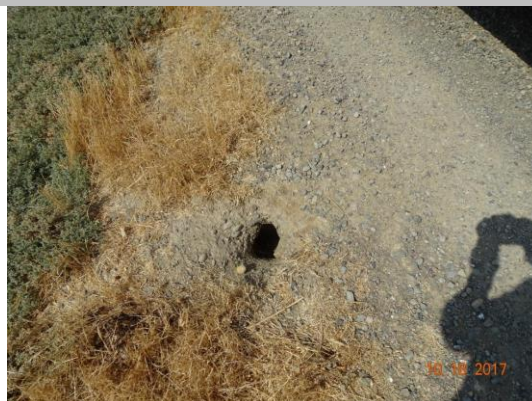
Photo 1 of 1 : FA_2020_NA0010_124_67_20200901_00007.jpg

Looking east at the landside slope.

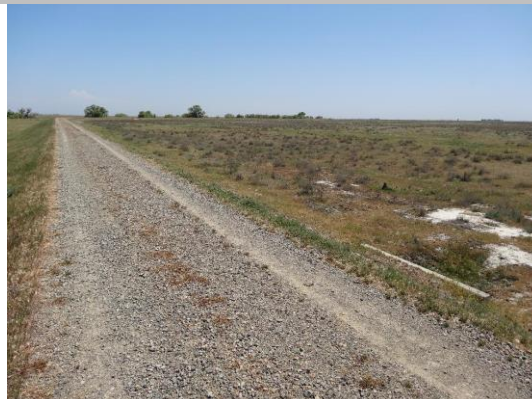
Photo 2 of 3 : UCIP_FA_2020_62244_66412.jpg

View of landward side.

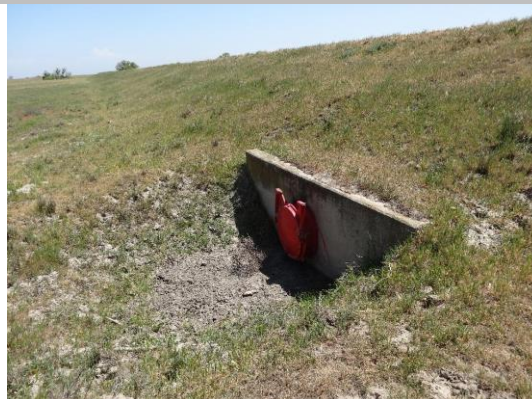
Photo 3 of 3 : UCIP_FA_2020_62244_66411.jpg

View of flap gate visible on waterward side.

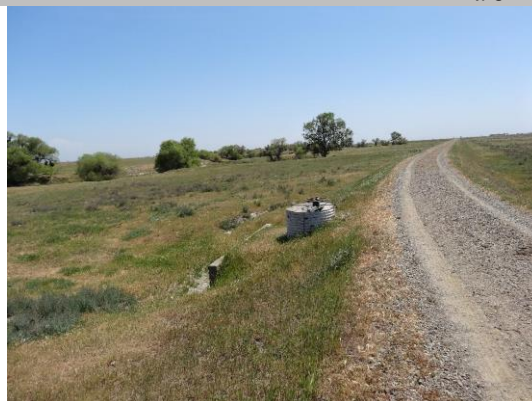
Photo 1 of 3 : UCIP_FA_2020_62245_66407.jpg

DS_ID:19827
 FS_ID:62245
 EP_NO: N/A
 Repair Type: Non-Urgent
 EVAL Issue:
 Crossing Status: Found
 UCIP Comments: 04/18/2014 Sediment buildup inside crossing and is visible from landward side. Recommend clearing sediment buildup inside pipe and check wall integrity to determine condition. (O. Magana - DWR UCIP)
 FIELD_STRUCT_DESC: 36-inch corrugated metal gravity drainage pipe through the levee, 6.7 feet below the crown. Slide gate in a 48-inch corrugated metal pipe (CMP) riser on the waterside (WS) slope.
 [Additional Reference(s): DWR Levee Log, 2002 (HLM 3.98), listed as a 36-inch corrugated metal pipe (CMP). USACE San Joaquin O&M Manual, Unit 601 Part 1 (SRJ601.1), 1967, Revised 25 May 2011, (HLM 3.97), listed as a 36-inch CMP]
 FS Date: 4/18/2014

View of waterward side.

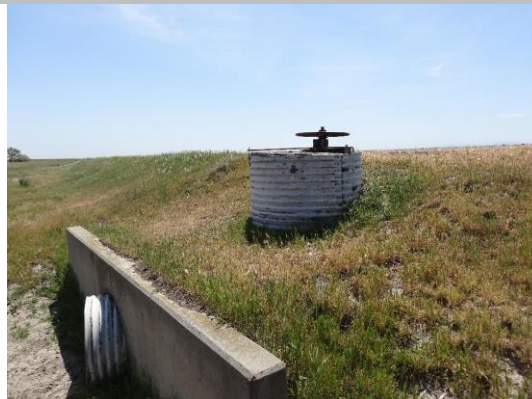
Photo 2 of 3 : UCIP_FA_2020_62245_66406.jpg

Slide gate inside CMP riser visible on waterward slope.

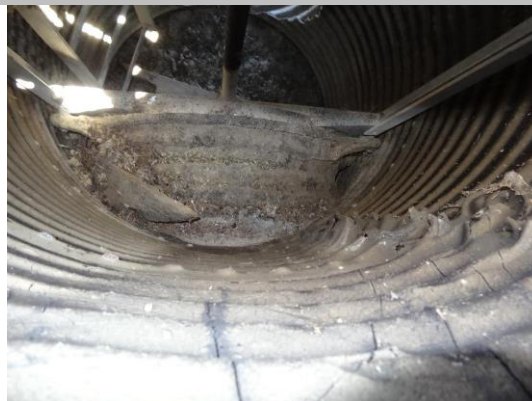
Photo 3 of 3 : UCIP_FA_2020_62245_66410.jpg

Inside view of CMP riser located on waterward side.

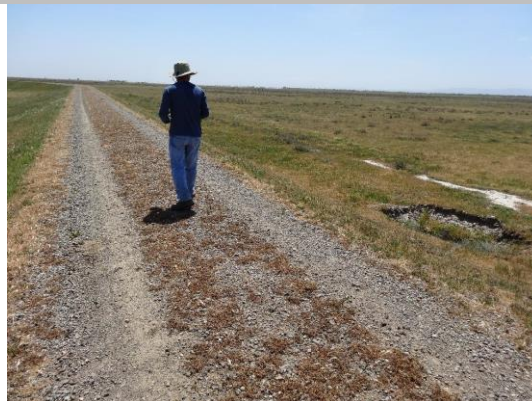
Photo 2 of 3 : UCIP_FA_2020_62246_66417.jpg

Overview of levee crown at crossing.

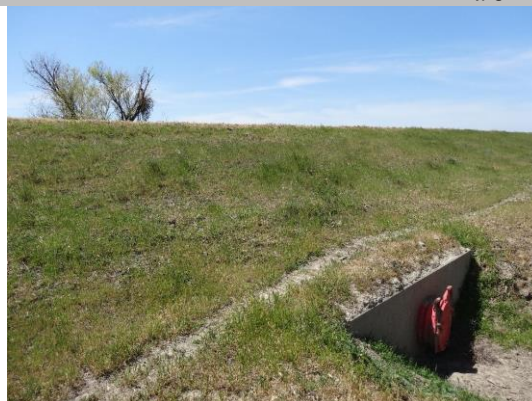
Photo 1 of 2 : UCIP_FA_2020_62247_66422.jpg

DS_ID:19829
 FS_ID:62247
 EP_NO: N/A
 Repair Type: Non-Urgent
 EVAL Issue:
 Crossing Status: Found
 UCIP Comments: 04/18/2014 Dense vegetation limits the inspector's visibility to identify signs of pipe condition on landward toe--headwall blocked by dense vegetation. Recommend removing vegetation from landward toe. (O. Magana - DWR UCIP)
 FIELD_STRUCT_DESC: 24-inch corrugated metal gravity drainage pipe through the levee, 11.3 feet below the crown. Flap gate on the waterside (WS) end. Concrete headwall on each end. [Additional Reference(s): DWR Levee Log, 2002 (HLM 4.43), listed as a 24-inch corrugated metal pipe (CMP). USACE San Joaquin O&M Manual, Unit 601 Part 1 (SRJ601.1), 1967, Revised 25 May 2011, (HLM 4.41), listed as a 24-inch CMP]
 FS Date: 4/18/2014

View of waterward side--concrete headwall and flap gate visible.

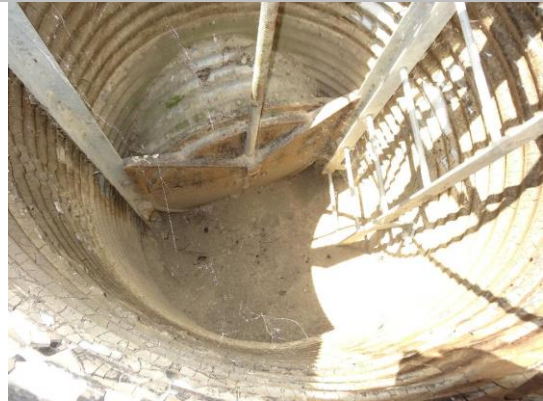
Photo 2 of 3 : UCIP_FA_2020_62248_66426.jpg

Inside view of CMP riser located on waterward.

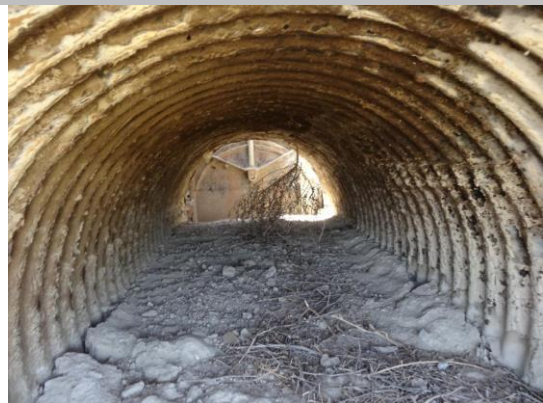
Photo 3 of 3 : UCIP_FA_2020_62248_66424.jpg

Inside view of pipe from waterward side.

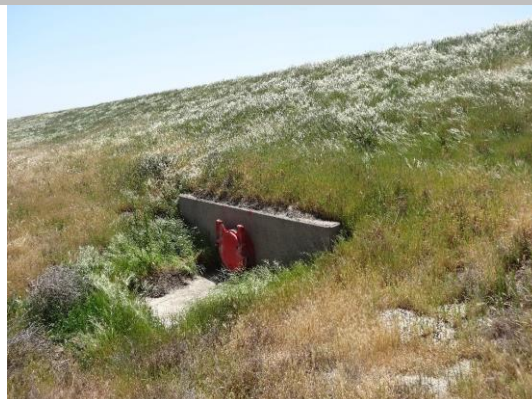
Photo 2 of 3 : UCIP_FA_2020_62249_66432.jpg

DS_ID:19831
FS_ID:62249
EP_NO: N/A
Repair Type: Non-Urgent
EVAL Issue:
Crossing Status: Found
UCIP Comments: 04/18/2014 Need to contact owner. Recommend removing tall grass on landward toe to determine condition of crossing from landward side. (O. Magana - DWR UCIP)
FIELD_STRUCT_DESC: 24-inch corrugated metal gravity drainage pipe through the levee, 11.8 feet below the crown. Flap gate on the waterside (WS) end. Concrete headwall on each end. [Additional Reference(s): DWR Levee Log, 2002 (HLM 4.75), listed as a 24-inch corrugated metal pipe (CMP). USACE San Joaquin O&M Manual, Unit 601 Part 1 (SRJ601.1), 1967, Revised 25 May 2011, (HLM 4.75), listed as a 24-inch CMP]
FS Date: 4/18/2014

Flap gate, concrete headwall and apron visible on waterward toe.

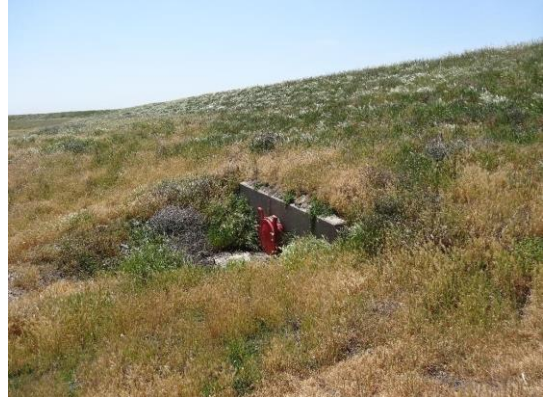
Photo 2 of 3 : UCIP_FA_2020_62250_66438.jpg

View of flap gate, concrete headwall and apron located on waterward side.

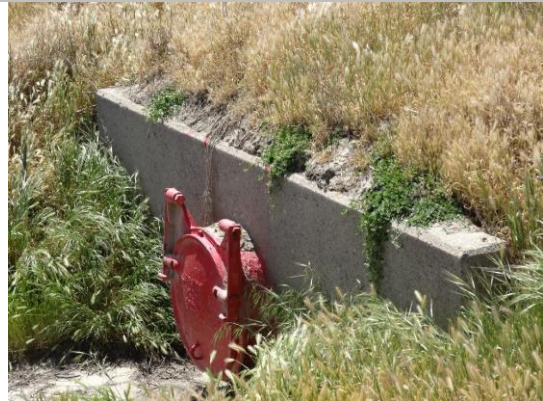
Photo 3 of 3 : UCIP_FA_2020_62250_66437.jpg

Close up of flap gate located on waterward side.

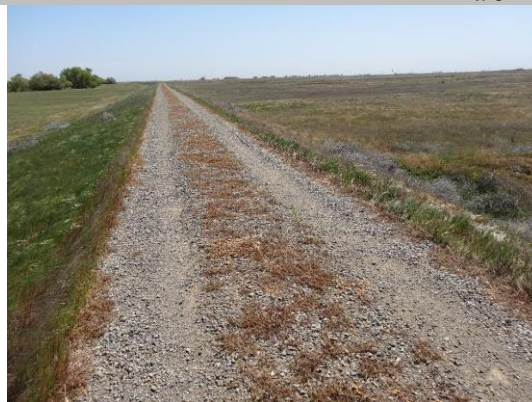
Photo 2 of 3 : UCIP_FA_2020_62251_61598.jpg

Overview of levee crown at crossing.

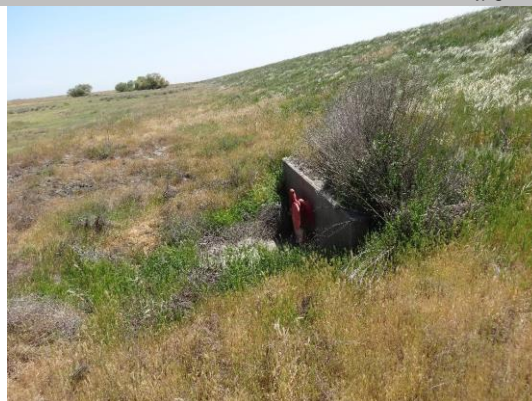
Photo 1 of 3 : UCIP_FA_2020_62252_66441.jpg

DS_ID:19864
 FS_ID:62252
 EP_NO: N/A
 Repair Type: Non-Urgent
 EVAL Issue:
 Crossing Status: Found
 UCIP Comments: 04/18/2014 Dense vegetation limits the inspector's visibility to identify signs of pipe failure (leaks) along the waterward slope. Recommend removing vegetation along pipe alignment to conduct proper inspection of structure. Also recommend removing excess vegetation at landward headwall. (O. Magana - DWR UCIP)
 FIELD_STRUCT_DESC: 24-inch corrugated metal gravity drainage pipe through the levee, 11 feet below the crown. Flap gate on the waterside (WS) end. Concrete headwall on each end. [Additional Reference(s): DWR Levee Log, 2002 (HLM 5.63), listed as a 24-inch corrugated metal pipe (CMP). USACE San Joaquin O&M Manual, Unit 601 Part 1 (SRJ601.1), 1967, Revised 25 May 2011, (HLM 5.63), listed as a 24-inch CMP]
 FS Date: 4/18/2014

Concrete headwall and flap gate visible on waterward toe.

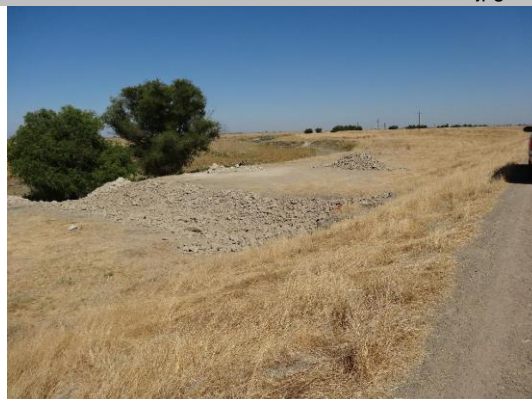
Photo 1 of 3 : UCIP_FA_2020_62253_75493.jpg

| DS_ID:19865 FS_ID:62253 EP_NO: N/A Repair Type: No Action Needed EVAL Issue: Crossing Status: Found UCIP Comments: 7/19/2016 Site has been repaired on WS and LS (see photos below). (O. Magana - DWR UCIP)5/26/2016 Erosion is undermining the WS headwall of drainage structure (photos of WS headwall provided by DWR Inspector R. Willoughby). Potential pipe failure at the outlet just behind headwall, recommend completing internal wall integrity of pipe length through levee to determine extent of damage to pipe. (O. Magana - DWR UCIP)4/18/2014 Need to contact owner. Sediment buildup in pipe visible on landside-- recommend clearing. (O. Magana - DWR UCIP) FIELD_STRUCT_DESC: 24-inch corrugated metal gravity drainage pipe through the levee, 9 feet below the crown. Flap gate on the waterside (WS) end. Concrete headwall on each end. [Additional Reference(s): DWR Levee Log, 2002 (HLM 6.06), listed as a 24-inch corrugated metal pipe (CMP). USACE San Joaquin O&M Manual, Unit 601 Part 1 (SRJ601.1), 1967, Revised 25 May 2011, (HLM 6.06), listed as a 24-inch CMP] FS Date: 7/19/2016 | | | | | |

View of WS--rock protection along drainage path.

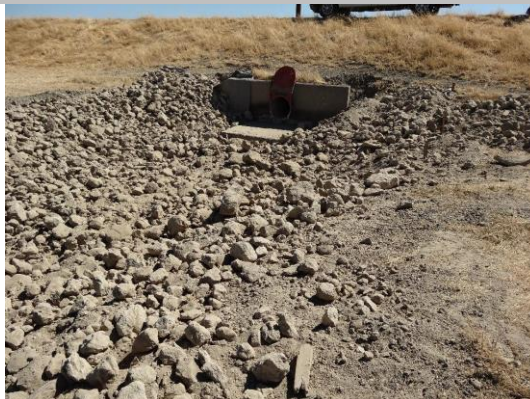
Photo 2 of 3 : UCIP_FA_2020_62253_75488.jpg

WS drainage path protected by rip rap.

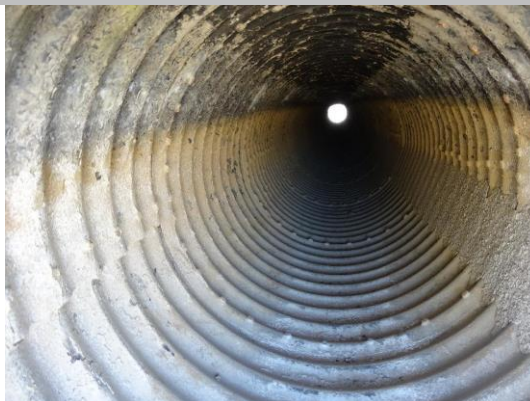
Photo 3 of 3 : UCIP_FA_2020_62253_75489.jpg

Inside view of pipe from WS.

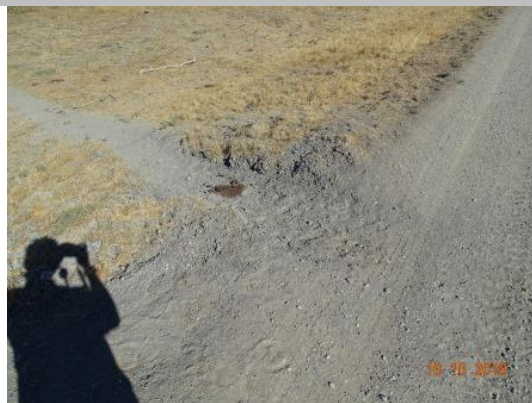
Photo 1 of 1 : FA_2020_NA0010_124_85_20200901_00021.jpg

| Livestock damage to slope and shoulder of levee. | | | | | |

View of livestock damage on waterside slope. (Fall 2018)

| A2 : Repair the levee slope damaged by livestock and prevent large animal access. | | | | | |
