Flood Control Project Maintenance Levee Inspections

Fall 2020 Levee Maintenance Deficiency Summary Report

San Joaquin River Basin

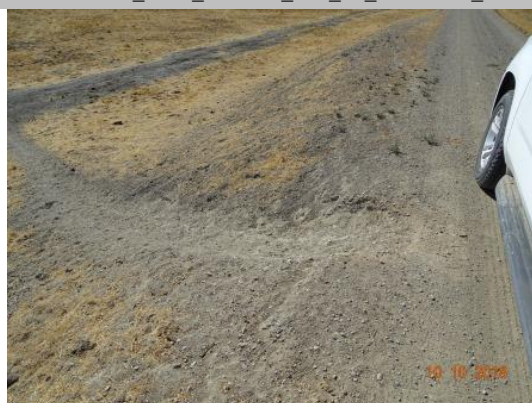
Photo 1 of 1 : FA_2020_NA0010_124_84_20200901_00020.jpg

| Damage to slope and crown from livestock. | | | | | |

Erosion to slope and into crown from livestock. (Fall 2018)

| A2 : Repair the levee slope damaged by livestock and prevent large animal access. | | | | | |

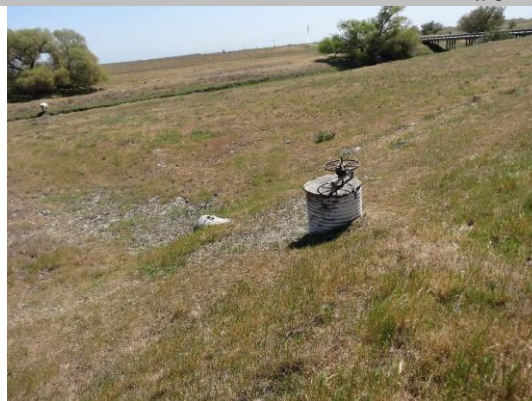
Photo 1 of 3 : UCIP_FA_2020_62258_61628.jpg

| DS_ID:19866 FS_ID:62258 EP_NO: N/A Repair Type: No Action Needed EVAL Issue: Crossing Status: Found UCIP Comments: FIELD_STRUCT_DESC: 24-inch corrugated metal gravity drainage pipe through the levee, 7 feet below the crown. Slide gate in a 36-inch corrugated metal pipe (CMP) riser on the waterside (WS) slope. Concrete headwall on the landside (LS) end. Concrete saddle and apron on the WS end. [Additional Reference(s): DWR Levee Log, 2002 (HLM 6.78), listed as a 24-inch corrugated metal pipe (CMP). USACE San Joaquin O&M Manual, Unit 601 Part 1 (SRJ601.1), 1967, Revised 25 May 2011, (HLM 6.79), listed as a 24-inch CMP] FS Date: 4/18/2014 | | | | | |

Slide gate inside CMP riser and pipe visible on waterward side.

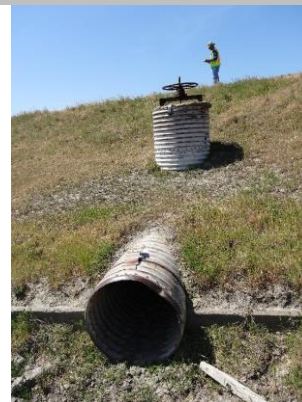
Photo 2 of 3 : UCIP_FA_2020_62258_61627.jpg

Concrete headwall visible on waterward side.

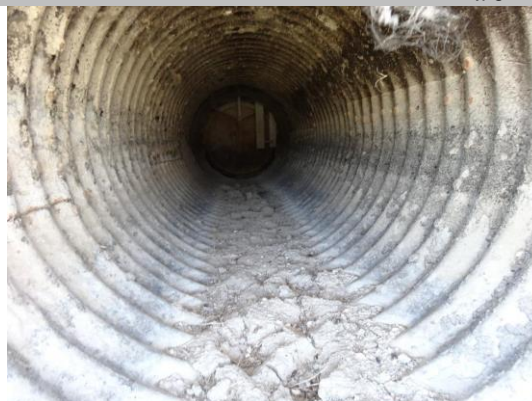
Photo 3 of 3 : UCIP_FA_2020_62258_61626.jpg

Inside view pipe from waterward side.

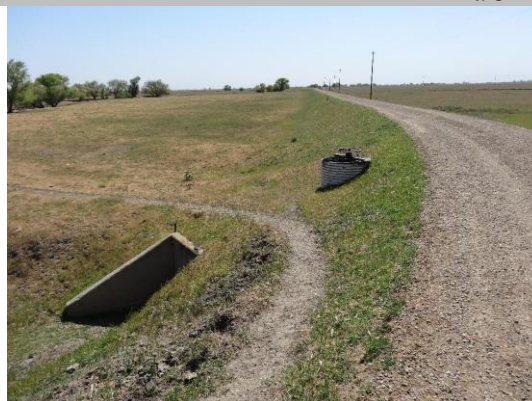
Photo 1 of 3 : UCIP_FA_2020_62255_61640.jpg

DS_ID:19867
 FS_ID:62255
 EP_NO: N/A
 Repair Type: No Action Needed
 EVAL Issue:
 Crossing Status: Found
 UCIP Comments:
 FIELD_STRUCT_DESC: 36-inch corrugated metal gravity drainage pipe through the levee, 10.7 feet below the crown. Slide gate in a 48-inch corrugated metal pipe (CMP) riser on the waterside (WS) slope. Concrete headwall on the landside (LS) end. Concrete U-shaped headwall on the WS end. [Additional Reference(s): DWR Levee Log, 2002 (HLM 6.97), listed as a 36-inch corrugated metal pipe (CMP). USACE San Joaquin O&M Manual, Unit 601 Part 1 (SRJ601.1), 1967, Revised 25 May 2011, (HLM 6.97), listed as a 36-inch CMP]
 FS Date: 4/18/2014

View of waterward side.

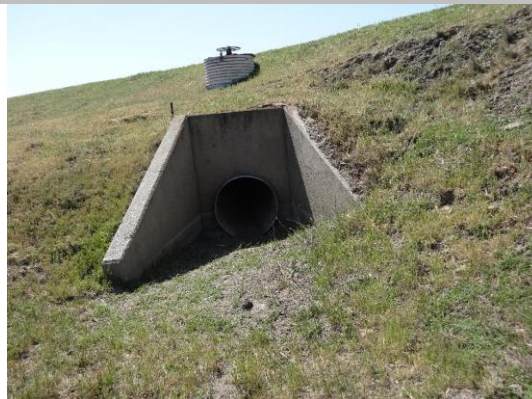
Photo 2 of 3 : UCIP_FA_2020_62255_61639.jpg

Concrete headwall and CMP riser visible on waterward side.

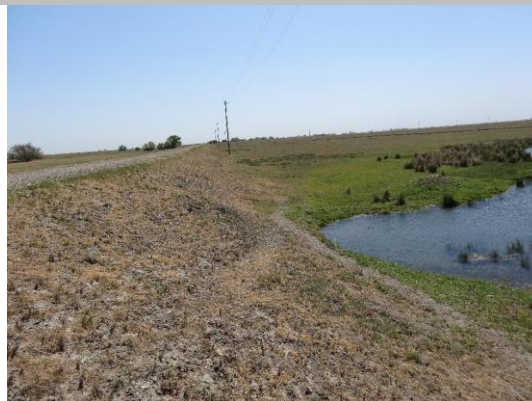
Photo 3 of 3 : UCIP_FA_2020_62255_61638.jpg

View of landward side.

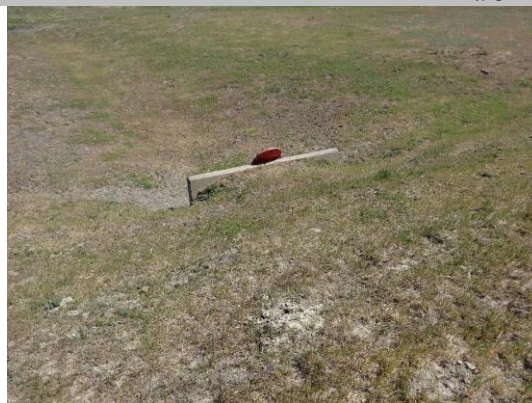
Photo 1 of 3 : UCIP_FA_2020_62256_61650.jpg

| DS_ID:19868 FS_ID:62256 EP_NO: N/A Repair Type: Non-Urgent EVAL Issue: Crossing Status: Found UCIP Comments: 04/18/2014 Need to contact owner. Clear animal from waterward side. Some sediment buildup in pipe visible landward side--recommend clearing. (O. Magana - DWR UCIP) FIELD_STRUCT_DESC: 24-inch corrugated metal gravity drainage pipe through the levee, 10.6 feet below the crown. Flap gate on the waterside (WS) end. Concrete headwall on each end. [Additional Reference(s): DWR Levee Log, 2002 (HLM 7.29), listed as a 24-inch corrugated metal pipe (CMP). USACE San Joaquin O&M Manual, Unit 601 Part 1 (SRJ601.1), 1967, Revised 25 May 2011, (HLM 7.29), listed as a 24-inch CMP] FS Date: 4/18/2014 | | | | | | |

View of waterward side.

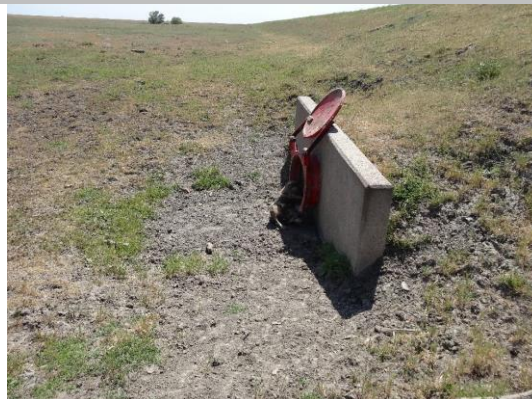
Photo 2 of 3 : UCIP_FA_2020_62256_61649.jpg

Concrete headwall and flap gate visible on waterward side. Dead animal inside pipe.

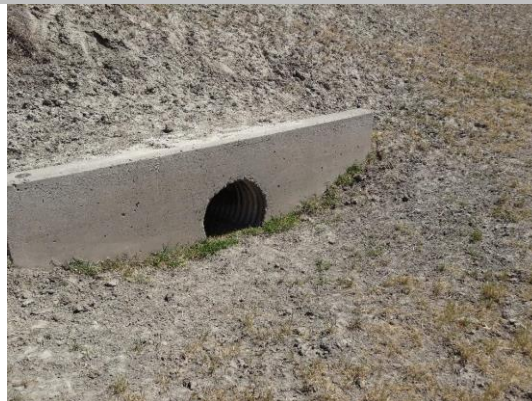
Photo 3 of 3 : UCIP_FA_2020_62256_61648.jpg

View of landward side.

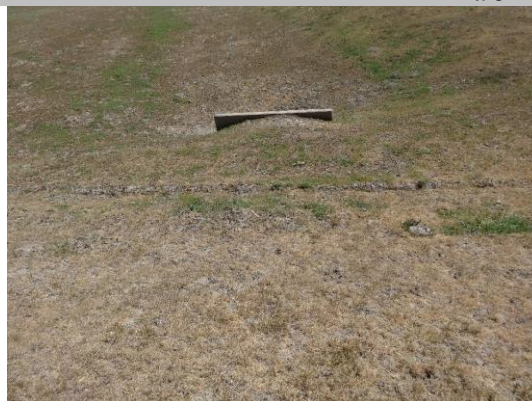
Photo 1 of 3 : UCIP_FA_2020_62257_66462.jpg

| UCIP Comments: 04/18/2014 Some sediment buildup in pipe visible on landward side--recommend clearing. (O. Magana - DWR UCIP) | | | | | | |

View of waterward side.

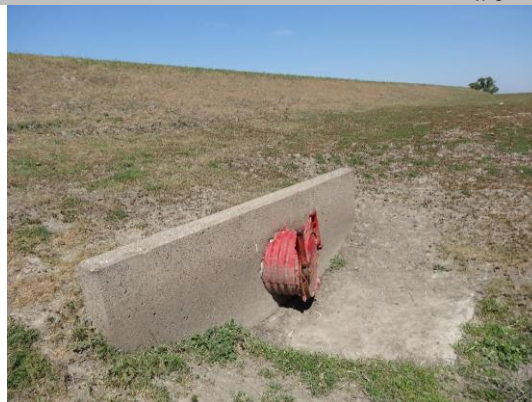
Photo 2 of 3 : UCIP_FA_2020_62257_66461.jpg

Pipe crosses levee at an angle.

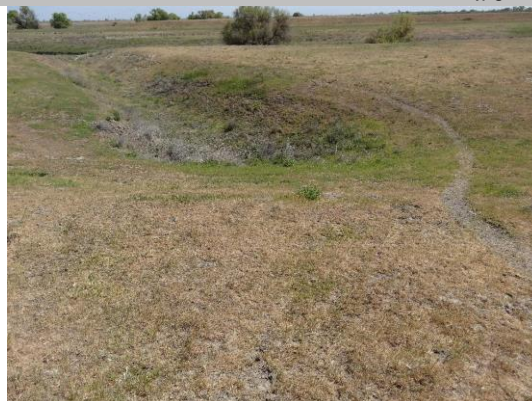
Photo 1 of 3 : UCIP_FA_2020_62259_61674.jpg

| DS_ID:19870 FS_ID:62259 EP_NO: N/A Repair Type: Non-Urgent EVAL Issue: Crossing Status: Found UCIP Comments: 04/18/2014 Sediment buildup in pipe--recommend contacting owner to clear sediment. (O. Magana - DWR UCIP) FIELD_STRUCT_DESC: 24-inch corrugated metal gravity drainage pipe through the levee, 16.5 feet below the crown. Flap gate on the waterside (WS) end. Concrete headwall on each end. [Additional Reference(s): DWR Levee Log, 2002 (HLM 8.22), listed as a 24-inch corrugated metal pipe (CMP). USACE San Joaquin O&M Manual, Unit 601 Part 1 (SRJ601.1), 1967, Revised 25 May 2011, (HLM 8.21), listed as a 24-inch CMP] FS Date: 4/18/2014 | | | | | | |

View of waterward side.

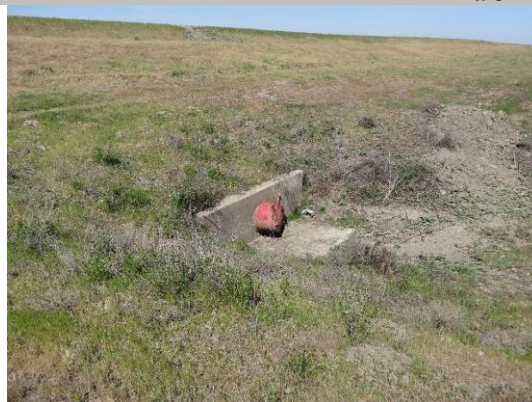
Photo 2 of 3 : UCIP_FA_2020_62259_61673.jpg

Pipe crosses levee at an angle.

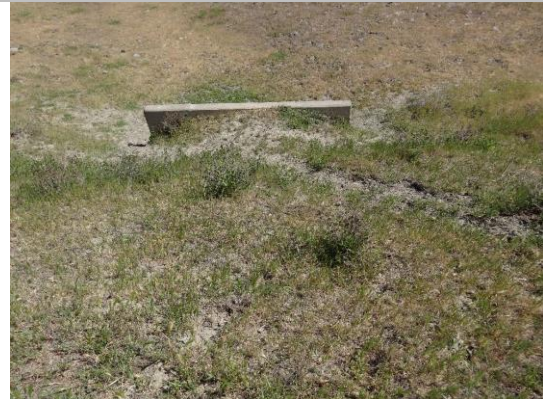
Photo 1 of 3 : UCIP_FA_2020_62260_61685.jpg

| DS_ID:19871 FS_ID:62260 EP_NO: N/A Repair Type: Non-Urgent EVAL Issue: Crossing Status: Found UCIP Comments: 04/18/2014 Need to contact owner. Sediment buildup in pipe visible on landward side--recommend clearing. Good candidate for pressure test or video inspection due to signs of heavy corrosion. If no leaks after tests this crossing would be a good candidate for rehabilitation. (O. Magana - DWR UCIP) FIELD_STRUCT_DESC: 24-inch corrugated metal gravity drainage pipe through the levee, 9.2 feet below the crown. Flap gate on the waterside (WS) end. Concrete headwall on each end. [Additional Reference(s): DWR Levee Log, 2002 (HLM 8.51), listed as a 24-inch corrugated metal pipe (CMP). USACE San Joaquin O&M Manual, Unit 601 Part 1 (SRJ601.1), 1967, Revised 25 May 2011, (HLM 8.51), listed as a 24-inch CMP] FS Date: 4/18/2014 | | | | | | |

View of waterward side.

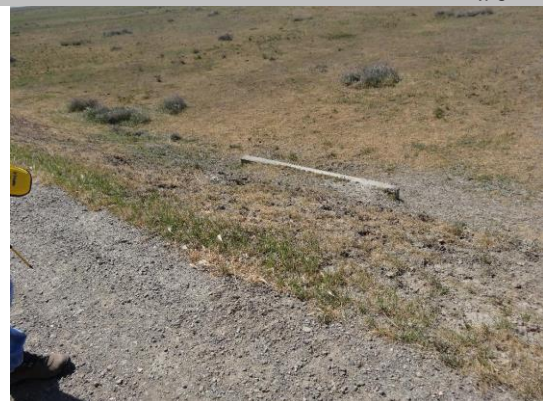
Photo 2 of 3 : UCIP_FA_2020_62260_61684.jpg

View of landward side.

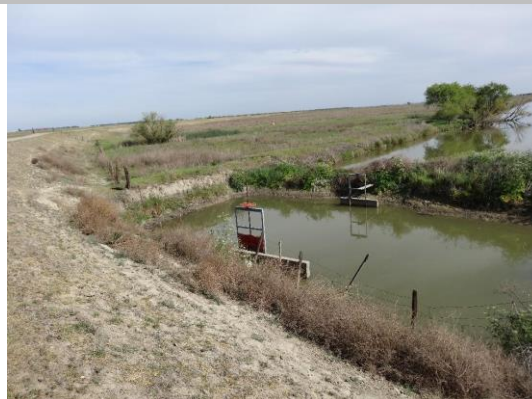
Photo 1 of 2 : UCIP_FA_2020_62266_61691.jpg

| DS_ID:19874 FS_ID:62266 EP_NO: N/A Repair Type: Non-Urgent EVAL Issue: Crossing Status: Found UCIP Comments: 04/17/2014 Waterward side not visible--need to determine alignment. (O. Magana - DWR UCIP) FIELD_STRUCT_DESC: 36-inch corrugated metal gravity drainage pipe through the levee, 14 feet below the crown. Slide gate in a concrete diversion box on the waterside (WS) shoulder. [Additional Reference(s): DWR Levee Log, 2002 (HLM 9.76), listed as a 36-inch corrugated metal pipe (CMP)]. FS Date: 4/17/2014 | | | | | |

View of landward side.

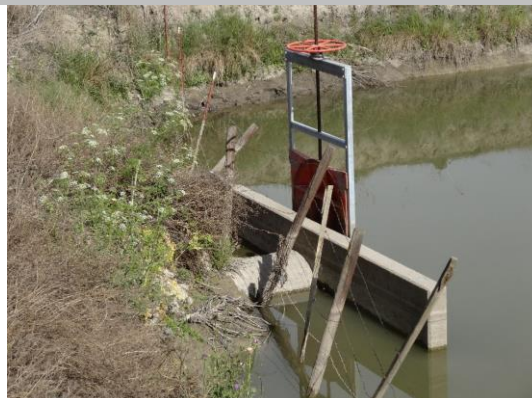
Photo 2 of 2 : UCIP_FA_2020_62266_61690.jpg

Pipe, slide gate, and concrete headwall visible on landward side.

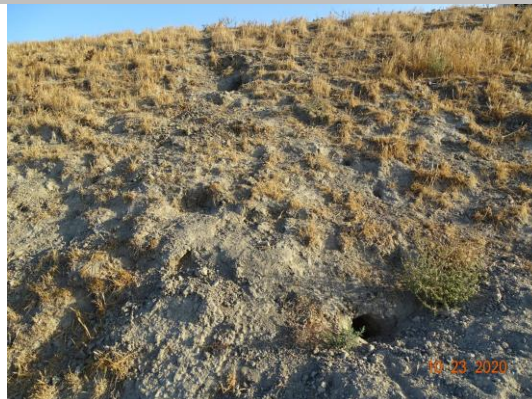
Photo 1 of 1 : FA_2020_NA0010_124_103_20201028_00181.jpg

Rodent holes in the landside slope. (Fall 2020)

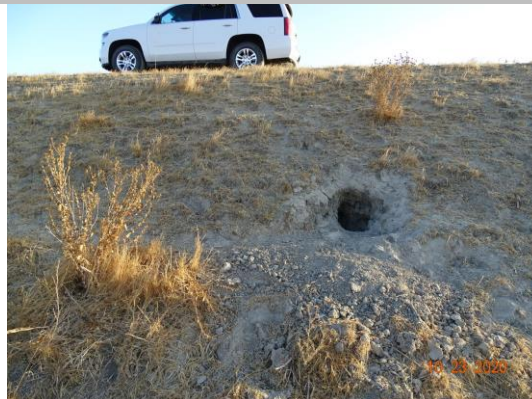
Photo 1 of 1 : FA_2020_NA0010_124_102_20201028_00182.jpg

View of large animal burrow in the landside slope. (Fall 2020)

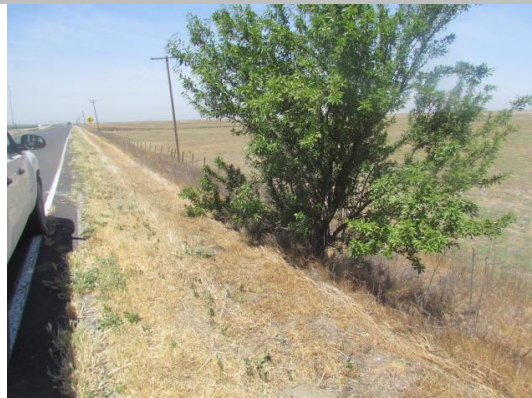
Photo 1 of 1 : FA_2020_NA0010_124_14_20200901_00003.jpg

| Almond tree located along Sandy Mush Road on waterside slope. | | | | | |

Looking west at tree on waterward slope.

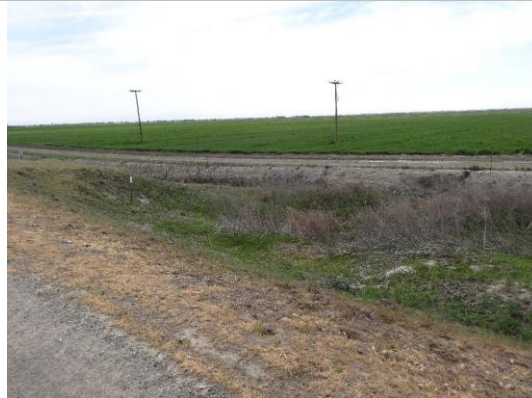
Photo 2 of 3 : UCIP_FA_2020_62268_66487.jpg

View of landward side.

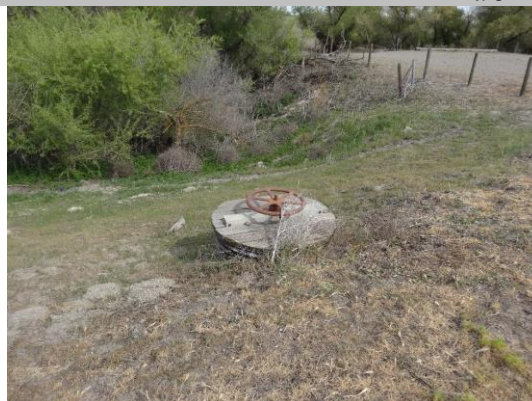
Photo 3 of 3 : UCIP_FA_2020_62268_66486.jpg

Slide gate inside CMP riser located on waterward slope.

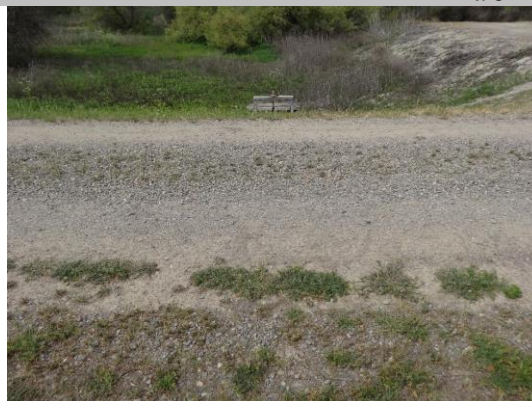
Photo 1 of 3 : UCIP_FA_2020_62270_66492.jpg

| DS_ID:19877 FS_ID:62270 EP_NO: N/A Repair Type: Non-Urgent EVAL Issue: Crossing Status: Found UCIP Comments: 04/17/2014 Not accessible--crossing is buried on landward side. Need to contact owner to determine status. (O. Magana - DWR UCIP) FIELD_STRUCT_DESC: 24-inch corrugated metal gravity drainage pipe through the levee, 10.8 feet below the crown. Flap gate on the waterside (WS) end. [Additional Reference(s): DWR Levee Log, 2002 (HLM 18.91), listed as a 24-inch corrugated metal pipe (CMP). USACE San Joaquin O&M Manual, Unit 601 Part 1 (SJR601.1), 1967, Revised 25 May 2011, (HLM 13.30), listed as a 24-inch CMP]. FS Date: 4/17/2014 | | | | | |

View of levee crown at crossing.

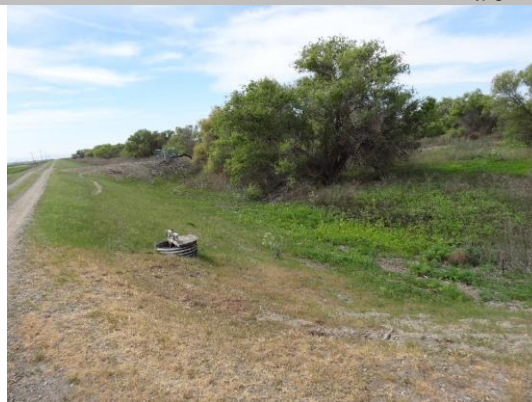
Photo 2 of 3 : UCIP_FA_2020_62270_66494.jpg

View of waterward slope.

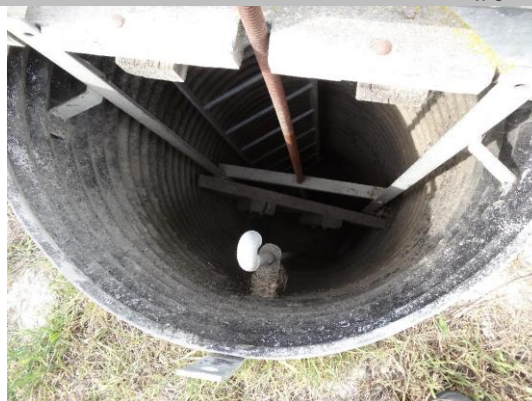
Photo 3 of 3 : UCIP_FA_2020_62270_66495.jpg

Inside view of CMP riser located on waterward slope.

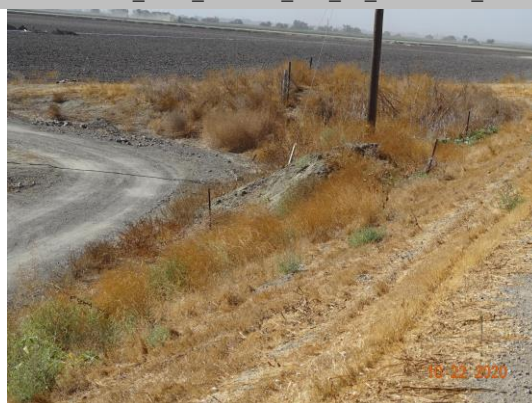
Photo 1 of 1 : FA_2020_NA0010_124_68_20201028_00183.jpg

| Landowner stockpiled dirt at landside toe. | | | | | |

Looking downstream at dirt stockpile on the landside toe. (Fall 2020)

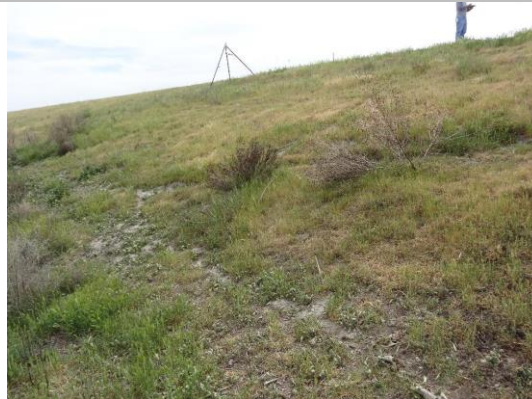
Photo 1 of 3 : UCIP_FA_2020_62271_66496.jpg

| DS_ID:19878 FS_ID:62271 EP_NO: N/A Repair Type: Non-Urgent EVAL Issue: Crossing Status: Found UCIP Comments: 04/17/2014 Not accessible--crossing is buried on landward side. Need to contact owner to determine status. (O. Magana - DWR UCIP) FIELD_STRUCT_DESC: 24-inch corrugated metal gravity drainage pipe through the levee, 12.3 feet below the crown. Flap gate on the waterside (WS) end. [Additional Reference(s): DWR Levee Log, 2002 (HLM 14.45), listed as a 24-inch corrugated metal pipe (CMP). USACE San Joaquin O&M Manual, Unit 601 Part 1 (SJR601.1), 1967, Revised 25 May 2011, (HLM 14.44), listed as a 24-inch CMP] FS Date: 4/17/2014 | | | | | |

View of waterward slope.

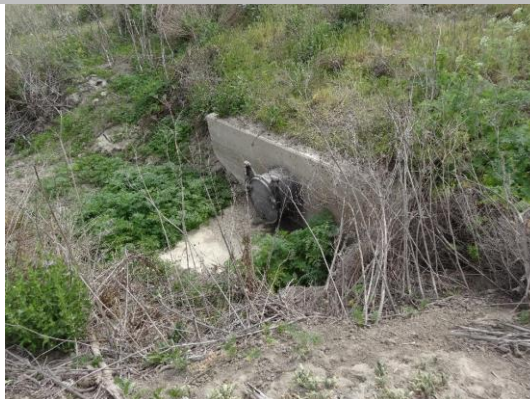
Photo 2 of 3 : UCIP_FA_2020_62271_66497.jpg

View of pipe daylight, flap gate, and concrete headwall visible on waterward toe.

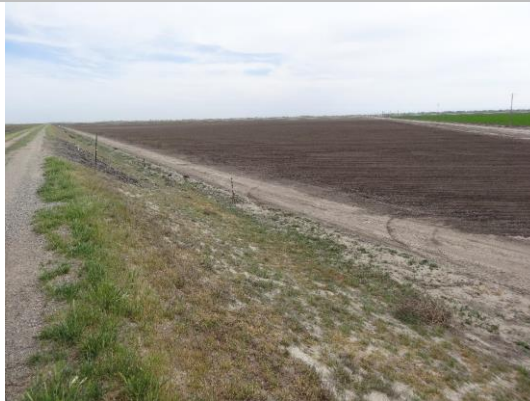
Photo 3 of 3 : UCIP_FA_2020_62271_66498.jpg

View of landward slope.

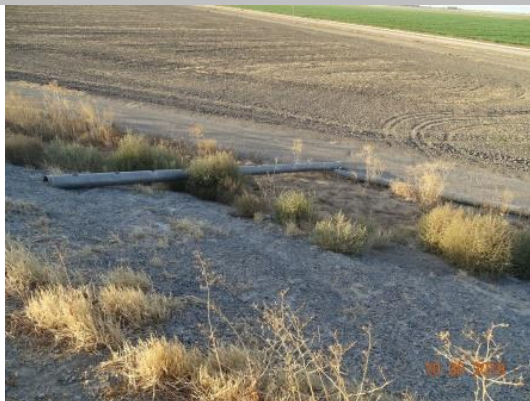
Photo 1 of 1 : FA_2020_NA0010_124_99_20200901_00027.jpg

| Pipe left on landside slope and toe. | | | | | |

View of pipe on landside slope and toe. (Fall 2019)

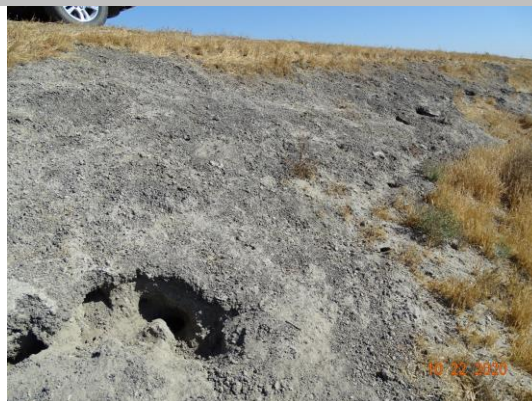
Photo 1 of 1 : FA_2020_NA0010_124_98_20201028_00184.jpg

Looking upstream along the waterside slope. (Fall 2020)

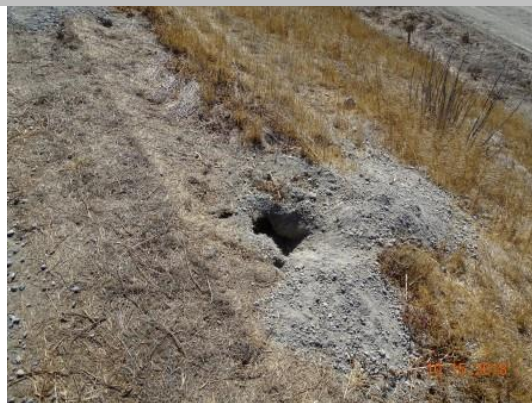
Photo 1 of 1 : FA_2020_NA0010_124_101_20200901_00028.jpg

| Burrows are located along landside shoulder. | | | | | |

View of rodent hole on landside shoulder. (Fall 2018)

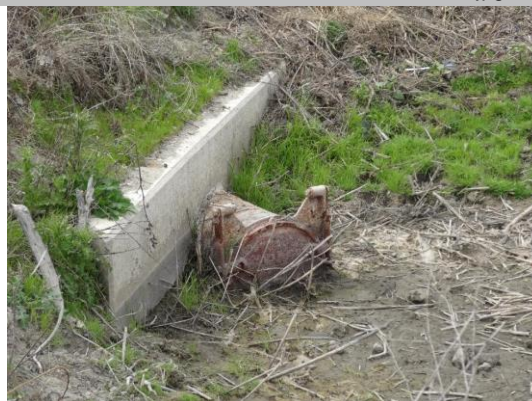
Photo 1 of 3 : UCIP_FA_2020_62272_66507.jpg

DS_ID:19884
FS_ID:62272
EP_NO: N/A
Repair Type: Non-Urgent
EVAL Issue:
Crossing Status: Found
UCIP Comments: 04/17/2014 Need to contact owner. Sediment buildup on both the waterward and landward side. Recommend removing sediment buildup from both side. Also recommend clearing excess sediment inside crossing. (O. Magana - DWR UCIP)
FIELD_STRUCT_DESC: 24-inch corrugated metal gravity drainage pipe through the levee, 14 feet below the crown. Flap gate on the waterside (WS) end. [Additional Reference(s): DWR Levee Log, 2002 (HLM 15.78), listed as a 24-inch corrugated metal pipe (CMP). USACE San Joaquin O&M Manual, Unit 601 Part 1 (SJR601.1), 1967, Revised 25 May 2011, (HLM 15.76), listed as a 24-inch CMP].
FS Date: 4/17/2014

Flap gate buried halfway on waterward side.

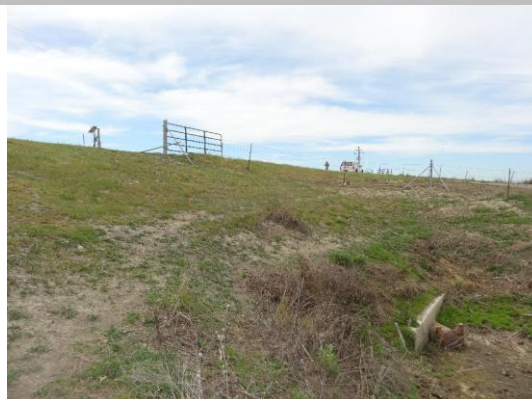
Photo 2 of 3 : UCIP_FA_2020_62272_66506.jpg

View of waterward side.

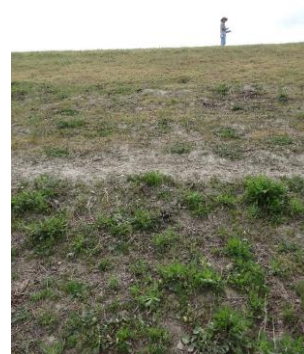
DS_ID:19885
 FS_ID:62273
 EP_NO: N/A
 Repair Type: Non-Urgent
 EVAL Issue:
 Crossing Status: Found
 UCIP Comments: 04/17/2014 Need to contact owner to determine status of crossing. Waterward side is buried and not accessible. Landward side headwall is blocked by dense vegetation. Recommend confirming status of flap gate on waterward side and removing dense vegetation form landward side. (O. Magana - DWR UCIP)
 FIELD_STRUCT_DESC: 36-inch corrugated metal gravity drainage pipe through the levee, 16.6 feet below the crown. Flap gate on the waterside (WS) end. [Additional Reference(s): DWR Levee Log, 2002 (HLM 15.93), listed as a 36-inch corrugated metal pipe (CMP). USACE San Joaquin O&M Manual, Unit 601 Part 1 (SJR601.1), 1967, Revised 25 May 2011, (HLM 15.91), listed as a 36-inch CMP]
 FS Date: 4/17/2014

View of waterward side, Photo 1 of 3.

View of waterward side, photo 2 of 3.

View of waterward side, photo 3 of 3.

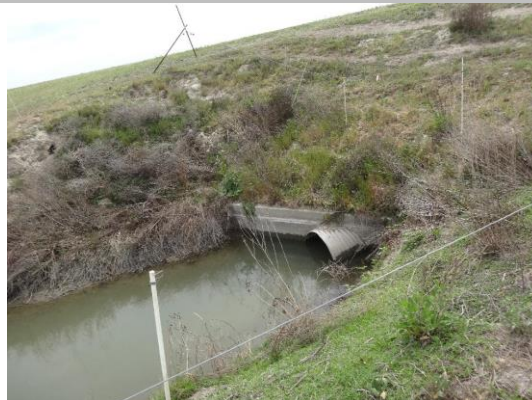
Photo 2 of 3 : UCIP_FA_2020_62274_66539.jpg

Concrete headwall and pipe visible on waterward side.

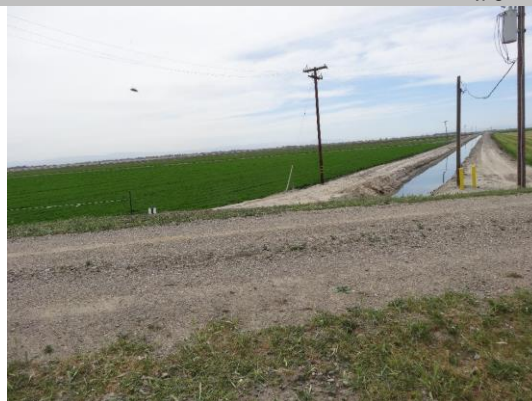
Photo 3 of 3 : UCIP_FA_2020_62274_66540.jpg

View of landward side, photo 1 of 2.

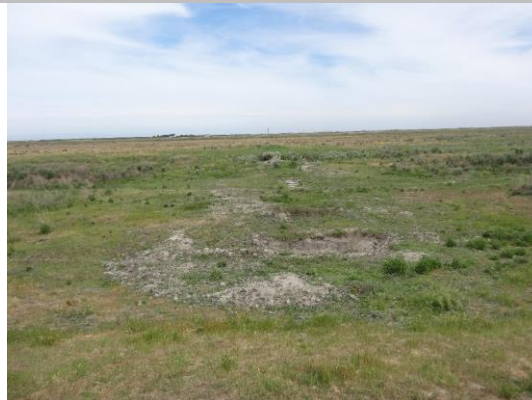
Photo 2 of 3 : UCIP_FA_2020_62269_66564.jpg

Overview of Eastside Bypass.

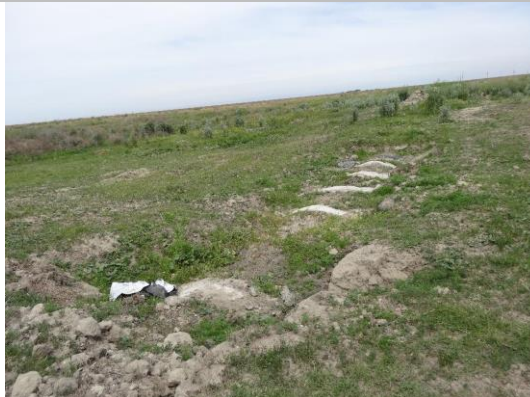
Photo 3 of 3 : UCIP_FA_2020_62269_66563.jpg

Channel sections have been excavated across Eastside Bypass.

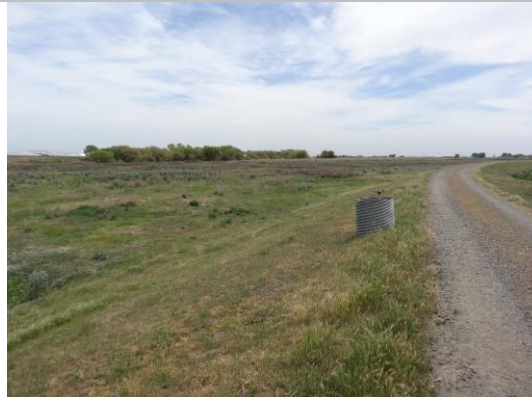
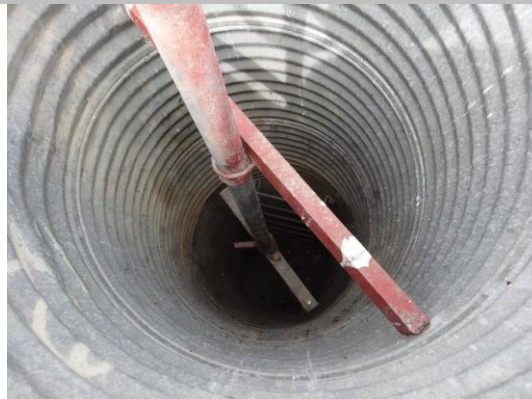
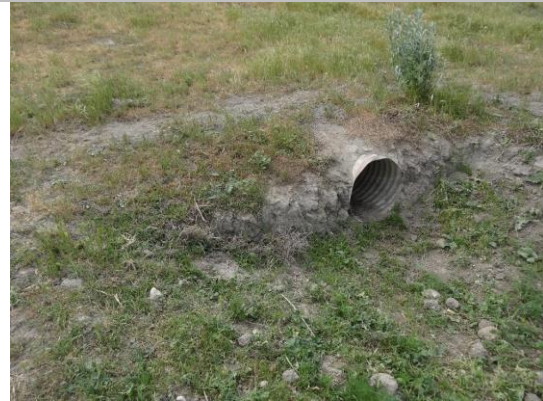
DS_ID:19889
FS_ID:62277
EP_NO: N/A
Repair Type: Non-Urgent
EVAL Issue:
Crossing Status: Found
UCIP Comments: 04/17/2014 Dense vegetation limits the inspector's visibility to identify signs of pipe failure (leaks) along the landward slope. Recommend removing vegetation along pipe alignment to conduct proper inspection of structure. (O. Magana - DWR UCIP)
FIELD_STRUCT_DESC: 24-inch corrugated metal gravity drainage pipe through the levee, 10.2 feet below the crown. Slide gate in a pipe riser on the waterside (WS) slope. [Additional Reference(s): DWR Levee Log, 2002 (HLM 18.98), listed as a 24-inch corrugated metal pipe (CMP). USACE San Joaquin O&M Manual, Unit 601 Part 1 (SJR601.1), 1967, Revised 25 May 2011, (HLM 18.97), listed as a 24-inch CMP].
FS Date: 4/17/2014

View of waterward side.

Inside view of CMP riser located on waterward slope.

Pipe daylight on waterward side.

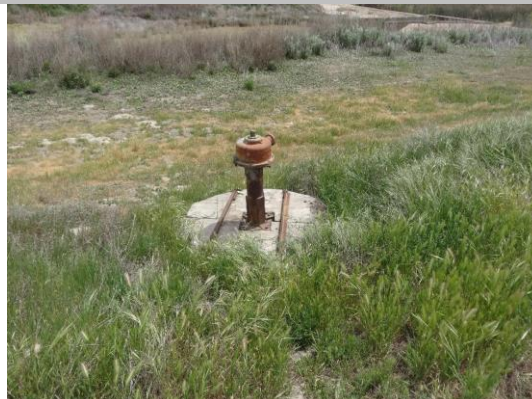
| DS_ID:19890 FS_ID:62278 EP_NO: N/A Repair Type: Non-Urgent EVAL Issue: Crossing Status: Found UCIP Comments: 04/17/2014 Dense vegetation limits the inspector's visibility to identify signs of pipe failure (leaks) along the slopes. Recommend removing vegetation along pipe alignment to conduct proper inspection of structure. (O. Magana - DWR UCIP) FIELD_STRUCT_DESC: 48-inch corrugated metal gravity drainage pipe through the levee, 20 feet below the crown. Slide gate in a pipe riser on the waterside (WS) slope. Riprap along the landside (LS) slope. [Additional Reference(s): DWR Levee Log, 2002 (HLM 19.36), listed as a 48-inch corrugated metal pipe (CMP). USACE San Joaquin O&M Manual, Unit 601 Part 1 (SJR601.1), 1967, Revised 25 May 2011, (HLM 19.36), listed as a 48-inch CMP]. FS Date: 4/17/2014 | | | | | | |

View of waterward side.

Riser located on waterward slope.

View of landward slope.

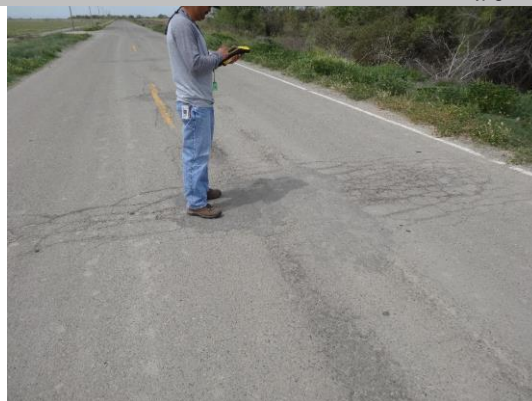
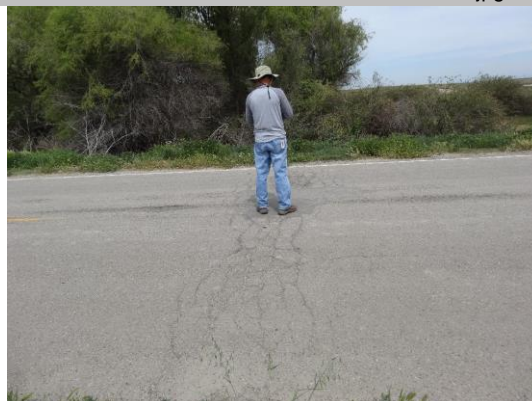
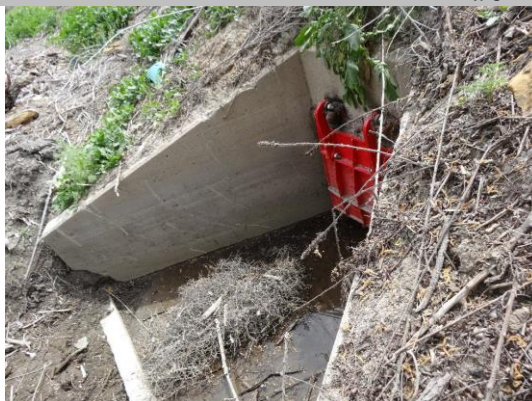
DS_ID:19891
FS_ID:62279
EP_NO: N/A
Repair Type: Non-Urgent
EVAL Issue:
Crossing Status: Found
UCIP Comments: 04/17/2014 Dense vegetation limits the inspector's visibility to identify signs of pipe failure (leaks) along the slopes. Recommend removing vegetation along pipe alignment to conduct proper inspection of structure. (O. Magana - DWR UCIP)
FIELD_STRUCT_DESC: 30-inch by 30-inch reinforced concrete box gravity drainage culvert through the levee, 14 feet below the crown. Flap gate on the waterside (WS) end. [Additional Reference(s): DWR Levee Log, 2002 (HLM 19.82), listed as a 2.5-foot by 2.5-foot reinforced concrete box culvert (RCBC). USACE San Joaquin O&M Manual, Unit 601 Part 1 (SJR601.1), 1967, Revised 25 May 2011, (HLM 19.85), listed as a 2.5-foot by 2.5 foot RCBC].
FS Date: 4/17/2014

Overview of levee crown looking downstream.

View of levee crown at crossing.

View of "U" concrete headwall located on waterward side.

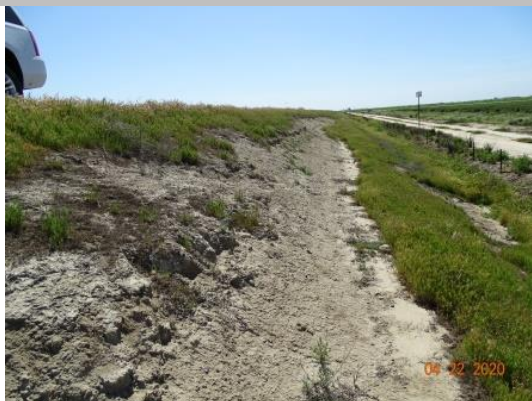
Photo 1 of 1 : FA_2020_NA0010_124_1209_20200901_00044.jpg

| Erosion on landside slope greater than 3 inches. Erosion caused by livestock. | | | | | |

Erosion on the landside slope from livestock activity. (Spring 2020)

| A2 : Repair the levee slope damaged by livestock and prevent large animal access. | | | | | |

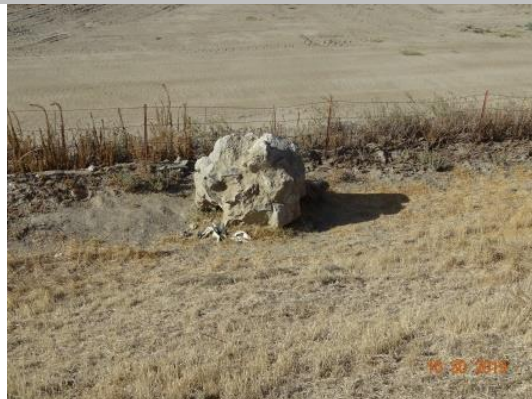
Photo 1 of 1 : FA_2020_NA0010_124_117_20200901_00035.jpg

| Large block of concrete left on the landside toe. | | | | | |

Large concrete block left on the landside toe. (Fall 2019)

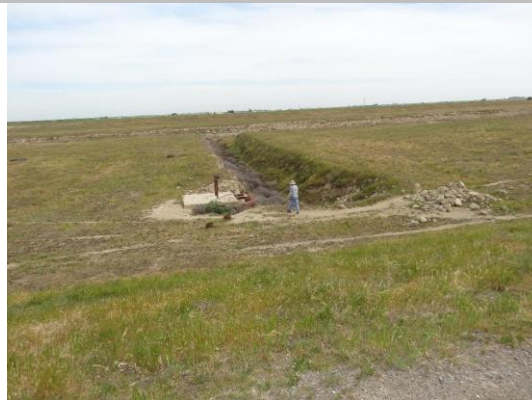
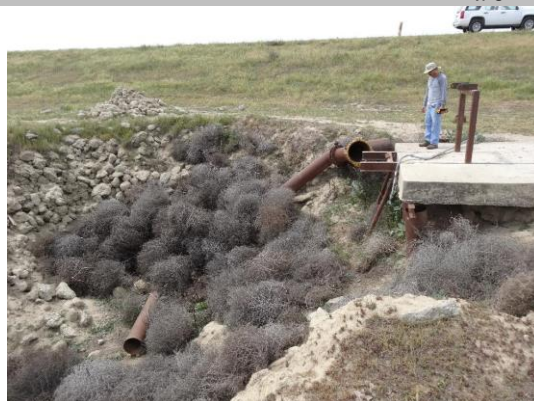
| DS_ID:19879 FS_ID:62281 EP_NO: 13638 Repair Type: Non-Urgent EVAL Issue: Crossing Status: Found UCIP Comments: 04/17/2014 Need to contact owner to determine status. Crossing has been modified. (O. Magana - DWR UCIP) FIELD_STRUCT_DESC: 16-inch coated steel irrigation discharge pipe through the levee, 3.5 feet below the crown. Cutoff wall around the pipe at the center of the levee. Pump on the waterside (WS). Siphon breaker on the landside (LS) shoulder. Intake trench on the WS. (Plans to install a pump with a 16-inch pipeline over the levee authorized under Permit No. 13638, 1983 - Hamonds Ranch). [Additional Reference(s): DWR Levee Log, 2002 (HLM 23.92), listed as a 16-inch steel pipe] FS Date: 4/17/2014 | | | | | | |

Overview of levee crown at crossing.

View of waterward side.

Concrete pad with abandoned support frame located on waterward side.

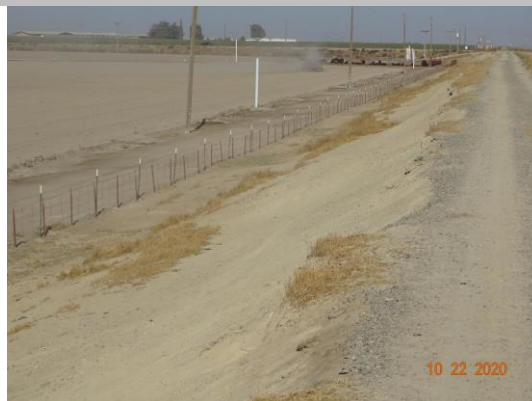
Photo 1 of 1 : FA_2020_NA0010_124_5_20201028_00188.jpg

| Landside erosion and slope instability caused by livestock extends into levee crown. At the worst locations erosion extends 2.5 feet to 3 feet from the shoulder into the crown. | | | | | |

Looking downstream at erosion from livestock. (Fall 2020)

| A2 : Repair the levee slope damaged by livestock and prevent large animal access. | | | | | |

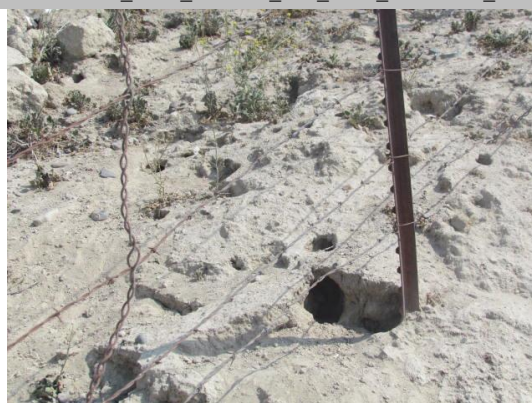
Photo 1 of 1 : FA_2020_NA0010_124_1208_20200901_00043.jpg

| Noted several rodent holes next to and within rock revetment on landside slope. | | | | | |

Rodent holes on landward slope.

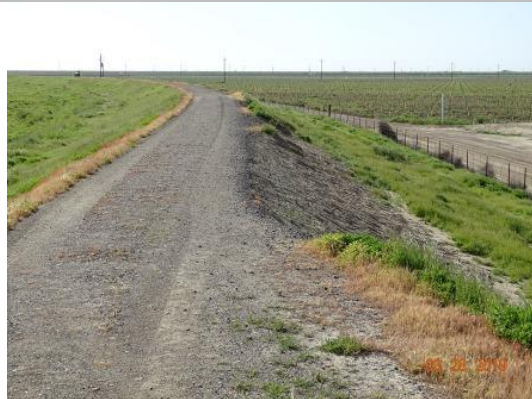
Photo 1 of 1 : FA_2020_NA0010_124_3_20200901_00001.jpg

| Landside erosion and slope instability caused by livestock. Erosion greater than 3" in depth on landside slope. Levee crown has narrowed within this reach. | | | | | |

Looking south along landside slope. (Spring 2019)

| A2 : Repair the levee slope damaged by livestock and prevent large animal access. | | | | | |

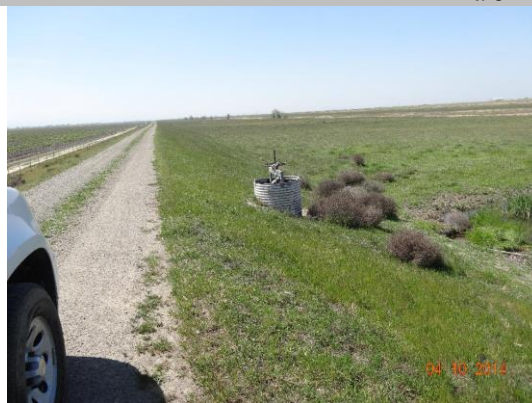
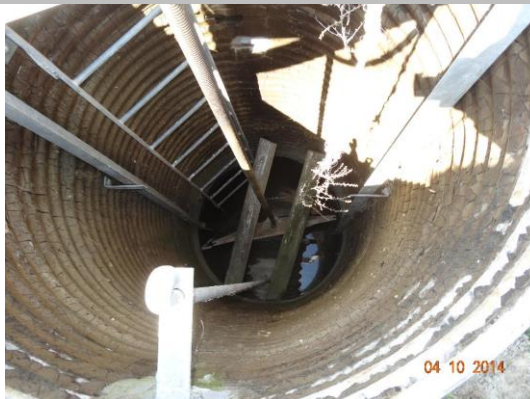
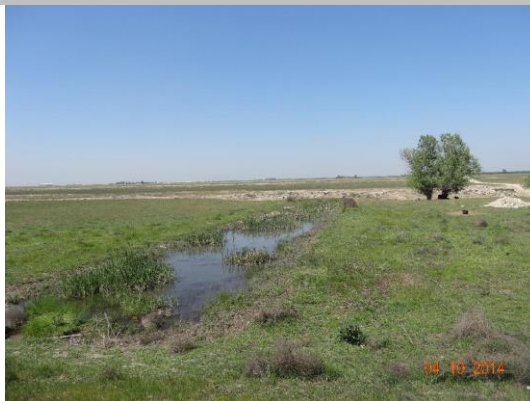
| DS_ID:19881 FS_ID:62283 EP_NO: N/A Repair Type: Non-Urgent EVAL Issue: Crossing Status: Found UCIP Comments: 04/10/2014 Dense vegetation limits the inspector's visibility to identify signs of pipe failure (leaks) along the slopes. Recommend removing vegetation along pipe alignment to conduct proper inspection of structure. (O. Magana - DWR UCIP) FIELD_STRUCT_DESC: 36-inch corrugated metal gravity irrigation pipe through the levee, 12.4 feet below the crown. Slide gate in a 48-inch corrugated metal pipe (CMP) riser on the waterside (WS) slope. Concrete U-shaped headwall on each end. Cobble pad on the landside (LS). [Additional Reference(s): DWR Levee Log, 2002 (HLM 29.34), listed as a 36-inch corrugated metal pipe (CMP). USACE San Joaquin O&M Manual, Unit 601 Part 1 (SJR601.1), 1967, Revised 25 May 2011, (HLM 29.34), listed as a 36-inch CMP]. FS Date: 4/10/2014 | | | | | |

View of waterward side--slide gate inside CMP riser located on waterward slope.

Inside view of CMP riser located on waterward slope.

View of waterward side.

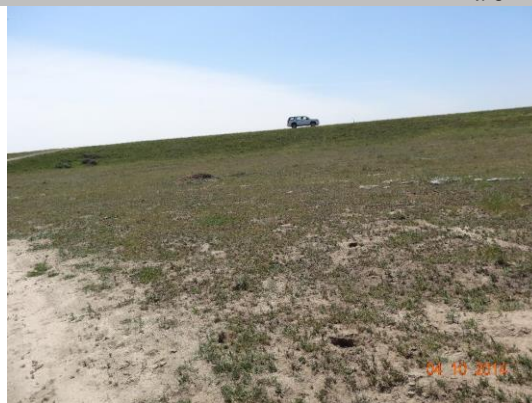
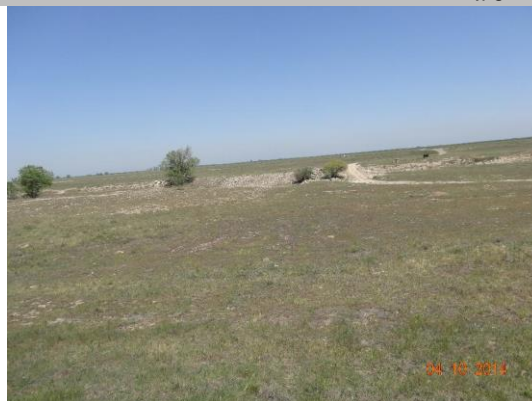
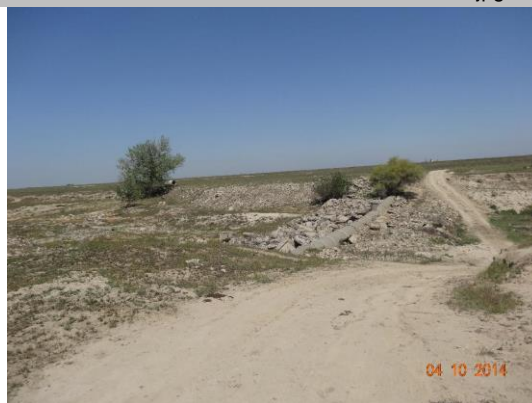
| DS_ID:19882 FS_ID:62284 EP_NO: N/A Repair Type: Non-Urgent EVAL Issue: Crossing Status: Found UCIP Comments: 04/10/2014 Altered crossing--steel pipe section on landward side and concrete pipe section on waterward side. Joints on waterward side seperated. Need to contact owner to determine status. (O. Magana - DWR UCIP) FIELD_STRUCT_DESC: [Rodunder Siphon Structure] 48-inch reinforced concrete irrigation siphon pipe through the levee, 14.5 feet below the crown. Concrete U-shaped headwall on the outlet structure on the landside (LS) end. Slide gate mounted on the headwall. [Additional Reference(s): DWR Levee Log, 2002 (HLM 30.26), listed as a 48-inch corrugated metal pipe (CMP). USACE San Joaquin O&M Manual, Unit 601 Part 1 (SJR601.1), 1967, Revised 25 May 2011, (HLM 30.27), listed as a 48-inch CMP]. FS Date: 4/10/2014 | | | | | |

Overview of waterward side.

Overview of Eastside Bypass at crossing.

Concrete pipe through Eastside Bypass exposed.

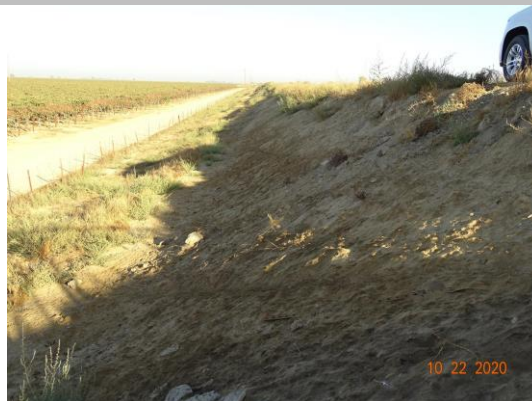
Photo 1 of 1 : FA_2020_NA0010_124_1207_20201028_00189.jpg

| Landside erosion greater than 1" in depth and greater than 3" in length. Erosion is caused by livestock traffic. | | | | | |

Looking upstream at livestock damage to the landside slope. (Fall 2020)

| A2 : Repair the levee slope damaged by livestock and prevent large animal access. | | | | | |

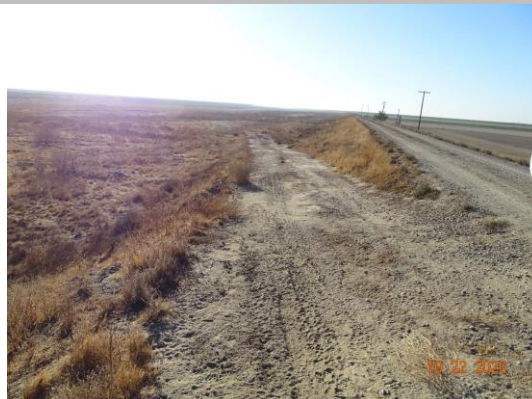
Photo 1 of 1 : FA_2020_NA0010_124_80_20201028_00190.jpg

| Farmer installed ramp on waterside slope. | | | | | |

Looking upstream at ramp on the waterside slope. (Fall 2020)

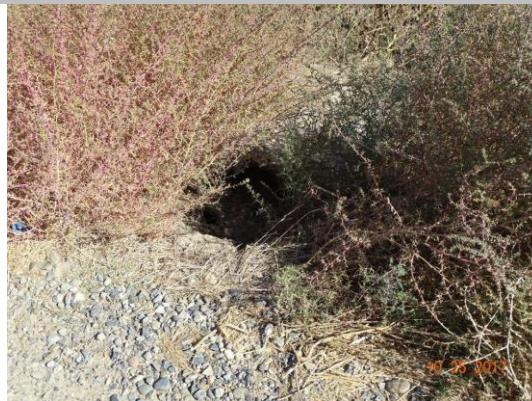
Photo 1 of 1 : FA_2020_NA0010_124_82_20200901_00017.jpg

Looking east at the waterside slope.

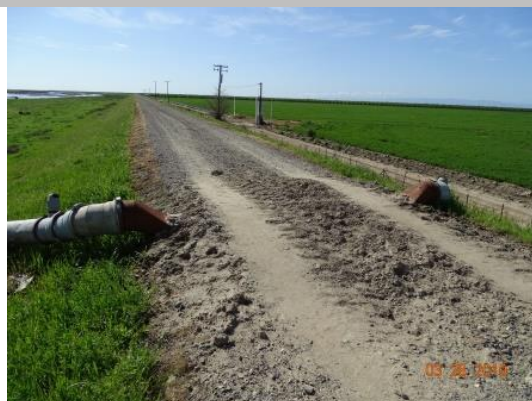
Photo 1 of 1 : FA_2020_NA0010_124_128_20200901_00038.jpg

| Temporary pipe is installed across levee crown by landowner. | | | | | |

View of pipe crossing looking upstream. (Spring 2019)

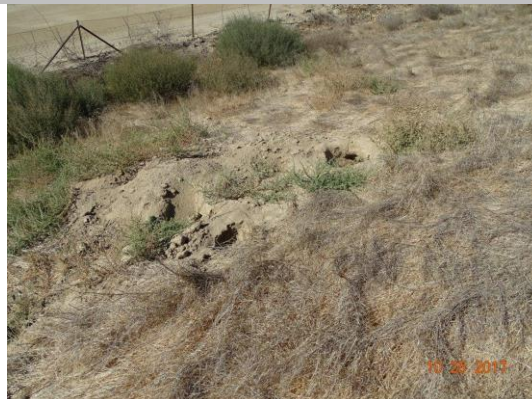
Photo 1 of 1 : FA_2020_NA0010_124_81_20200901_00016.jpg

Looking west at the landside slope.

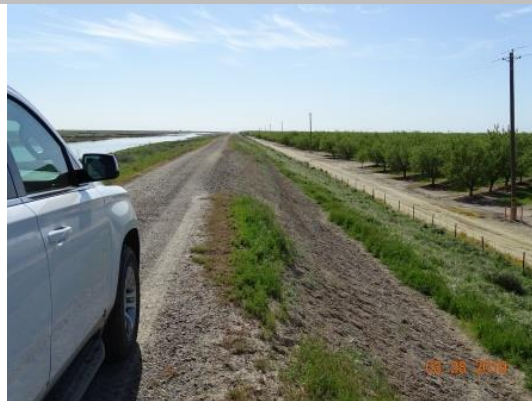
Photo 1 of 1 : FA_2020_NA0010_124_129_20200901_00039.jpg

| Slope damage from livestock. Damage is beginning to erode into levee crown. | | | | | |

Erosion from animal activity along the landside slope. (Spring 2019)

| A2 : Repair the levee slope damaged by livestock and prevent large animal access. | | | | | |

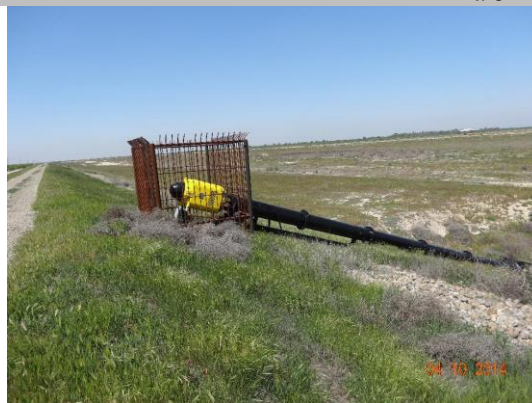
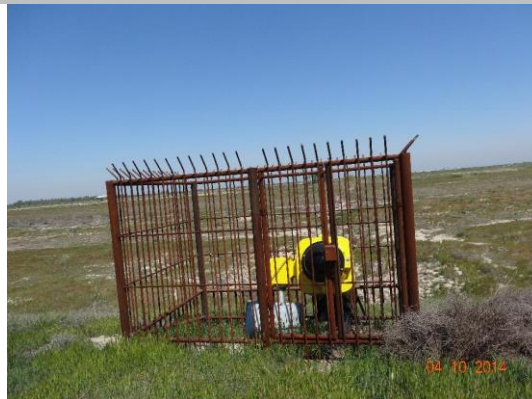
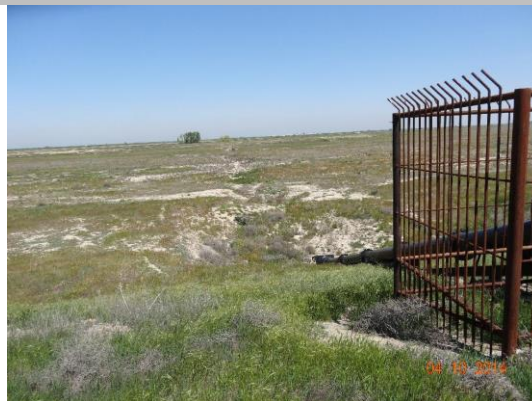
| DS_ID:19883 FS_ID:62285 EP_NO: 6416-C Repair Type: Non-Urgent EVAL Issue: Crossing Status: Found UCIP Comments: 04/10/2014 Crossing updated--need to contact owner to determine permit issued by CVFPB for authorized changes. (O. Magana - DWR UCIP) FIELD_STRUCT_DESC: 20-inch coated steel drainage discharge pipe through the levee, 3.9 feet below the crown. Electrical conduit through the levee. Cutoff wall around pipe at centerline of levee. Capped with a welded plate on the landside (LS) end. Siphon breaker on the apex of the pipe on the LS shoulder. Slant pump on the waterside (WS) slope. (To revise plans for a slant pump and an 18-inch steel pipe through the levee authorized under Permit No. 6416-A, 1975 - Triangle T. Ranch, Inc.). [Additional Reference(s): DWR Levee Log, 2002 (HLM 32.97), listed as a 18-inch steel pipe]. FS Date: 4/10/2014 | | | | | | |

View of waterward side--pipe and pump fenced off on waterward slope.

Electrical conduit visible on waterward slope.

View of Eastside Bypass.

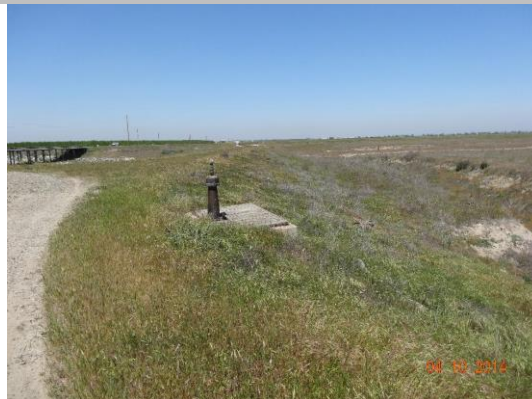
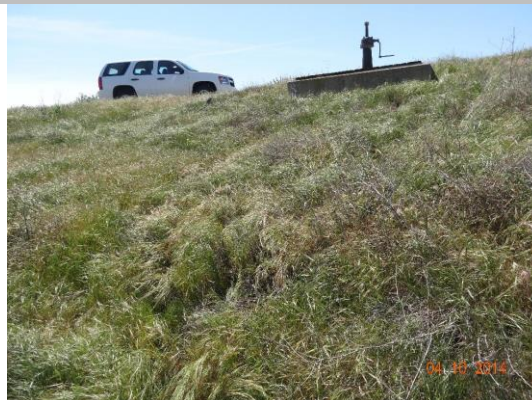
| DS_ID:19813 FS_ID:62287 EP_NO: N/A Repair Type: Non-Urgent EVAL Issue: Crossing Status: Found UCIP Comments: 04/10/2014 Dense vegetation limits the inspector's visibility to identify signs of pipe failure (leaks) along the slope. Recommend removing vegetation along pipe alignment to conduct proper inspection of structure and appurtenances. High vegetation along crossing alignment--recommend removing vegetation along pipe crossing. (O. Magana - DWR UCIP) FIELD_STRUCT_DESC: [Fresno River Irrigation Structure] 48-inch by 72-inch reinforced concrete box gravity irrigation culvert through the levee, 15.1 feet below the crown. Slide gate in a concrete riser in the waterside (WS) slope. Concrete U-shaped headwall on each end. Landside (LS) channel cobble revetted for 8 feet. [Additional Reference(s): DWR Levee Log, 2002 (HLM 35.33), listed as a 48-inch by 72-inch reinforced concrete box culvert (RCBC). USACE San Joaquin O&M Manual, Unit 601 Part 1 (SJR601.1), 1967, Revised 25 May 2011, (HLM 35.33), listed as a 6-foot by 4-foot RCBC, known as the Fresno River Irrigation Structure]. FS Date: 4/10/2014 | | | | | | |

View of waterward side--slide gate inside concrete box.

View of waterward slope covered by dense vegetation.

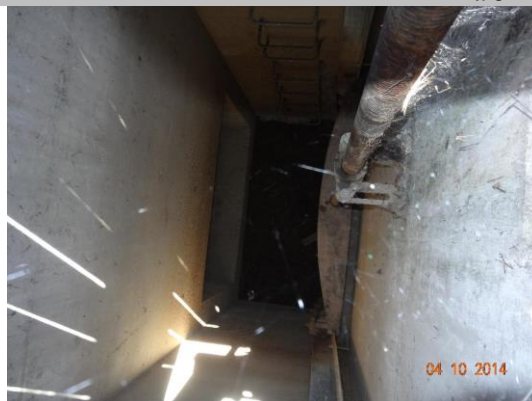
Photo 3 of 3 : UCIP_FA_2020_62287_66629.jpg

Inside view of concrete box located on waterward slope.

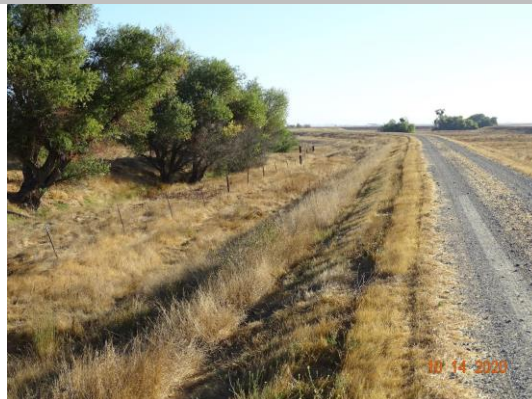
Photo 1 of 1 : FA_2020_NA0010_125_17_20201028_00043.jpg

View of vegetation on the landside slope. (Fall 2020)

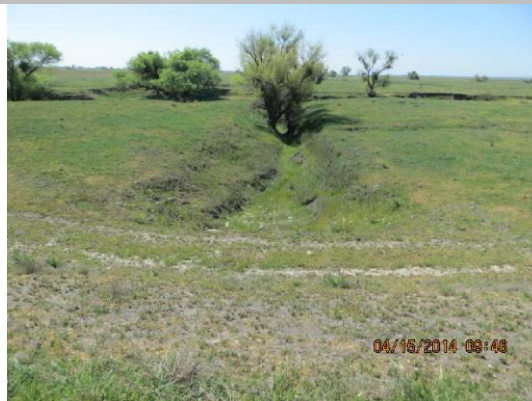
Photo 1 of 3 : UCIP_FA_2020_62031_60954.jpg

| DS_ID:19892 FS_ID:62031 EP_NO: N/A Repair Type: Non-Urgent EVAL Issue: Crossing Status: Found UCIP Comments: 07/20/2016 Inlet blocked off by wooden board. Dense vegetation limits the inspector's visibility to identify signs of pipe failure (leaks) along WS and LS. Crossing downgraded from Urgent to Non-Urgent. (O. Magana - DWR UCIP)04/15/2014 Flapgate partially blocked by soil buildup at WS toe. (W. Wylie - DWR UCIP) FIELD_STRUCT_DESC: 24-inch corrugated metal gravity drainage pipe through the levee, 10.8 feet below the crown. Flap gate on the waterside (WS) end. Concrete headwall on the landside (LS) end. Concrete U-shaped headwall on the WS end. [Additional Reference(s): DWR Levee Log, 2002 (HLM 0.08), listed as a 24-inch corrugated metal pipe (CMP). USACE San Joaquin O&M Manual, Unit 601 Part 1 (SJR601.1), 1967, (HLM 0.07), listed as a 24-inch CMP]. FS Date: 7/20/2016 | | | | | | |

Pipe and headwall at WS toe.

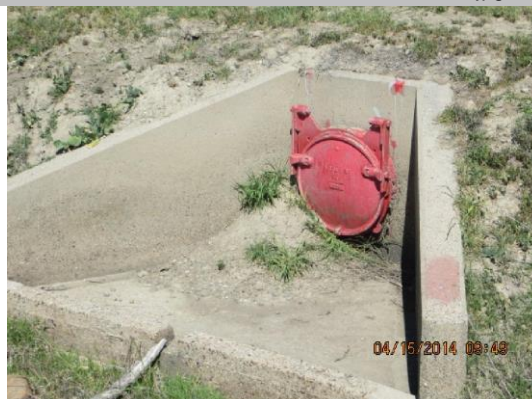
Photo 2 of 3 : UCIP_FA_2020_62031_60955.jpg

Pipe, headwall, and flapgate at WS toe. Soil buildup partially blocking flapgate.

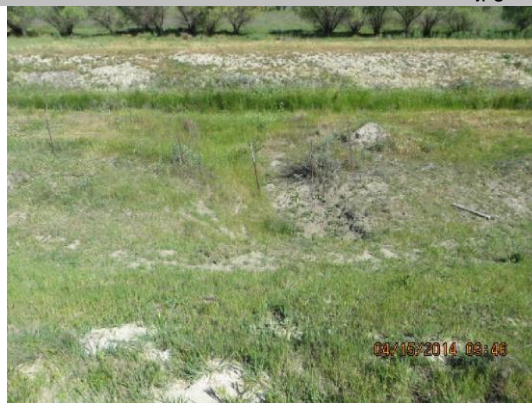
Photo 3 of 3 : UCIP_FA_2020_62031_60953.jpg

Pipe and headwall at LS toe.
