Flood Control Project Maintenance Levee Inspections

Fall 2020 Levee Maintenance Deficiency Summary Report

San Joaquin River Basin

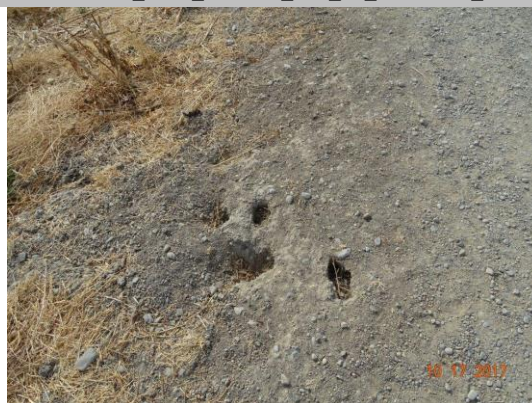
Photo 1 of 1 : FA_2020_NA0010_125_29_20200901_00009.jpg

| Several rodent holes were noted on the landside and waterside slope and shoulder. | | | | | |

Looking north at landside slope.

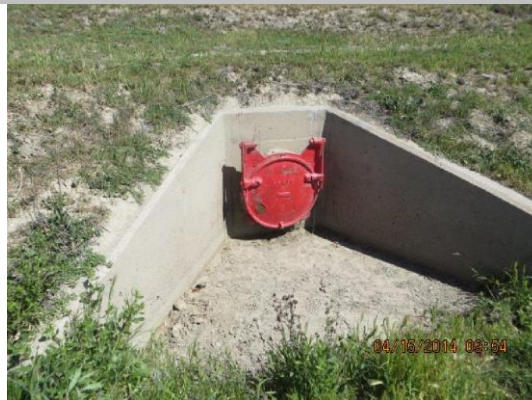
Photo 2 of 3 : UCIP_FA_2020_62044_60957.jpg

Pipe, headwall, and flapgate on WS toe.

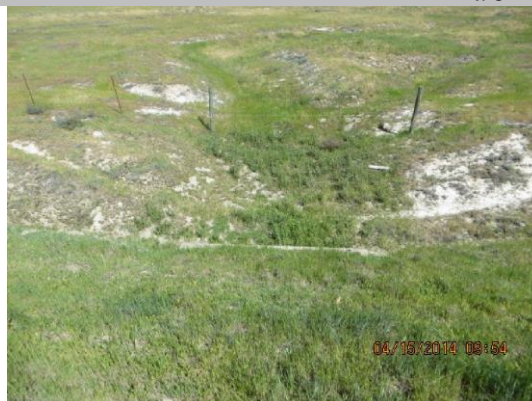
Photo 3 of 3 : UCIP_FA_2020_62044_60959.jpg

Pipe and headwall on LS toe.

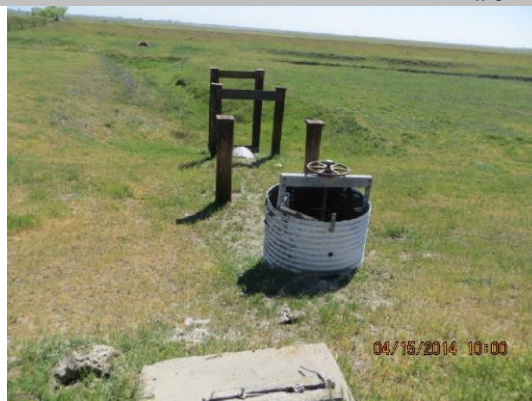
Photo 1 of 3 : UCIP_FA_2020_62042_60963.jpg

DS_ID:19894
 FS_ID:62042
 EP_NO: N/A
 Repair Type: Non-Urgent
 EVAL Issue:
 Crossing Status: Found
 UCIP Comments: 04/15/2014 Slide gate not operable, but left in closed position. Need to reinstall covers over slide gate standpipe. (W. Wylie - DWR UCIP)
 FIELD_STRUCT_DESC: 36-inch corrugated metal gravity drainage pipe through the levee, 9.7 feet below the crown. Slide gate in a 48-inch corrugated metal pipe (CMP) riser on the landside (LS) slope. Concrete U-shaped headwall on the LS end. Inlet channel cobble revetted. Dilapidated wooden pier on the waterside (WS). WS slope and outlet ditch cobble revetted. [Additional Reference(s): DWR Levee Log, 2002 (HLM 0.49), listed as a 36-inch corrugated metal pipe (CMP). USACE San Joaquin O&M Manual, Unit 601 Part 1 (SJR601.1), 1967, (HLM 0.49), listed as a 36-inch CMP].
 FS Date: 4/15/2014

Slide gate in CMP riser on WS slope.

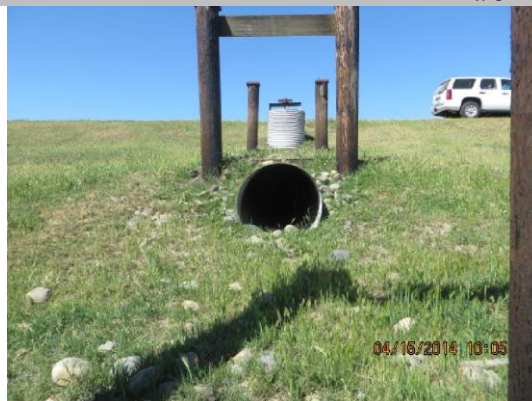
Photo 2 of 3 : UCIP_FA_2020_62042_60965.jpg

Outlet on WS slope.

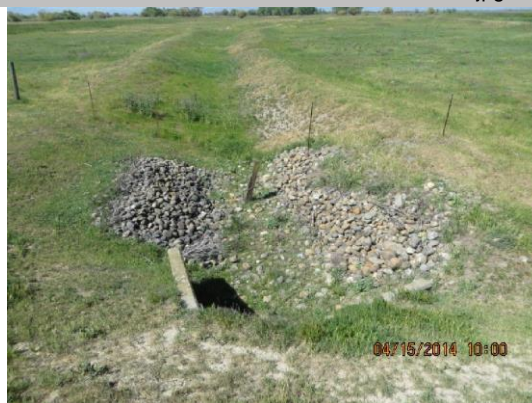
Photo 3 of 3 : UCIP_FA_2020_62042_60964.jpg

Pipe and headwall on LS toe.

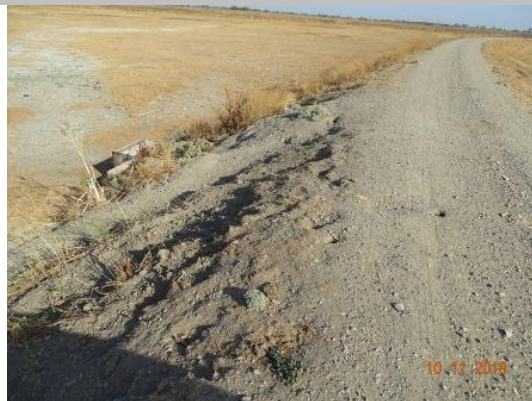
Photo 1 of 1 : FA_2020_NA0010_125_18_20200901_00005.jpg

| There is livestock damage to the landside slope. | | | | | |

View of damage from livestock looking upstream. (Fall 2018)

| A2 : Repair the levee slope damaged by livestock and prevent large animal access. | | | | | |

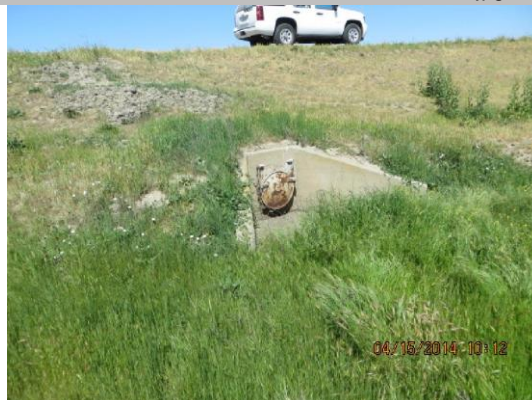
Photo 2 of 3 : UCIP_FA_2020_62045_60983.jpg

Flapgate on concrete headwall at WS toe.

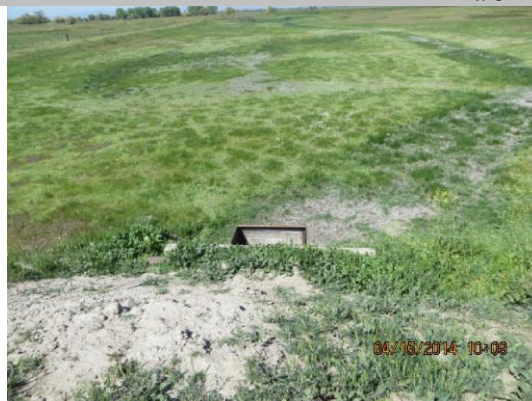
Photo 3 of 3 : UCIP_FA_2020_62045_60982.jpg

Headwall, pipe, and wier on LS toe.

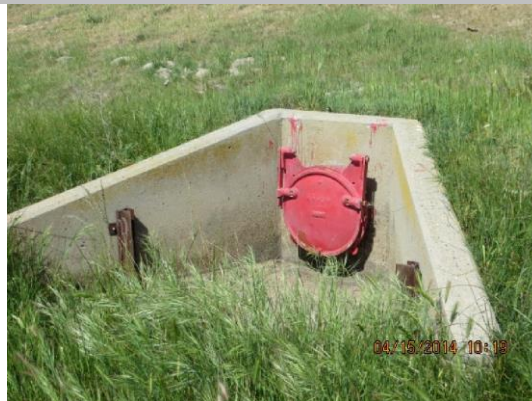
Photo 2 of 3 : UCIP_FA_2020_62035_60988.jpg

Headwall and flapgate on WS toe.

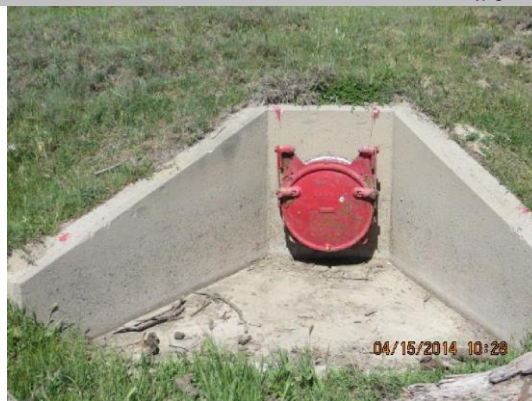
Photo 2 of 3 : UCIP_FA_2020_62036_60993.jpg

Concrete headwall and flapgate at WS toe.

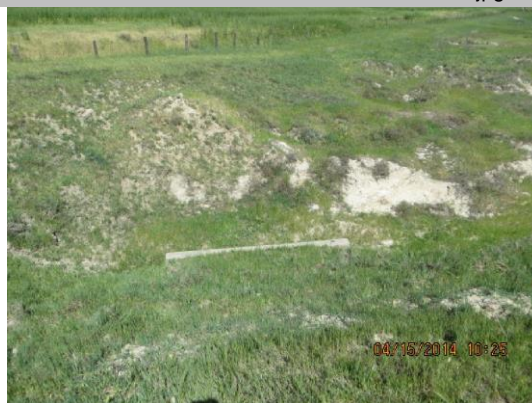
Photo 3 of 3 : UCIP_FA_2020_62036_60992.jpg

Concrete headwall and pipe on LS toe.

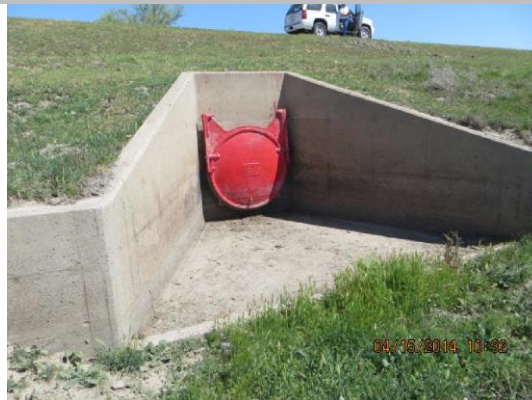
Photo 2 of 3 : UCIP_FA_2020_62043_60995.jpg

Flapgate at headwall on WS toe.

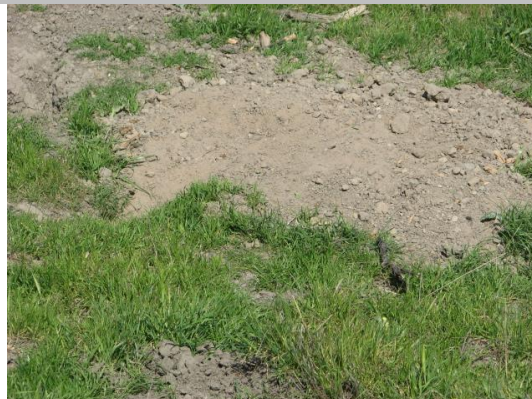
Photo 1 of 1 : FA_2020_NA0010_125_6_20200901_00002.jpg

Looking at typical view of rodent holes within this section. (Spring 2018)

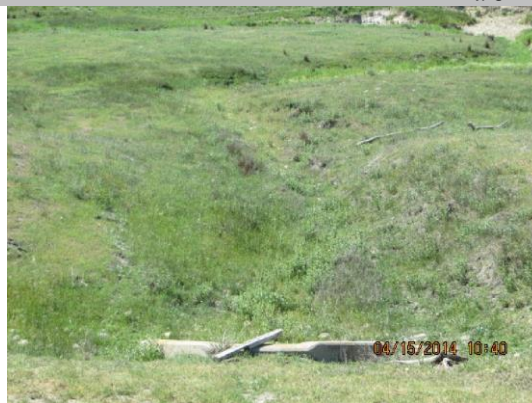
Photo 1 of 3 : UCIP_FA_2020_62038_61001.jpg

Pipe, headwall and flapgate on WS toe.

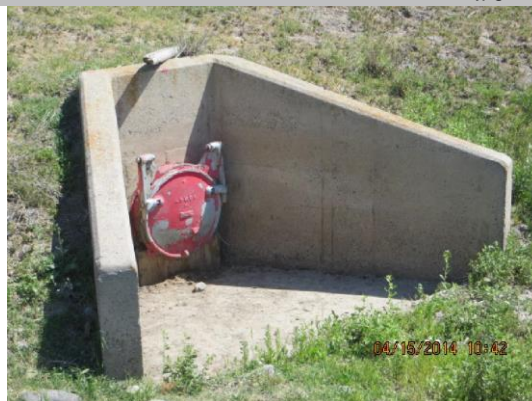
Photo 2 of 3 : UCIP_FA_2020_62038_61003.jpg

Pipe, headwall and flapgate on WS toe.

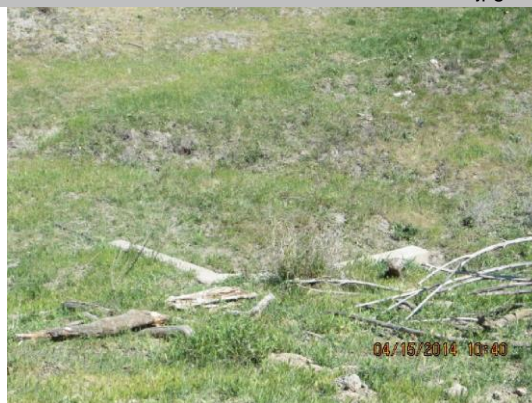
Photo 3 of 3 : UCIP_FA_2020_62038_61002.jpg

Headwall and pipe on LS toe.

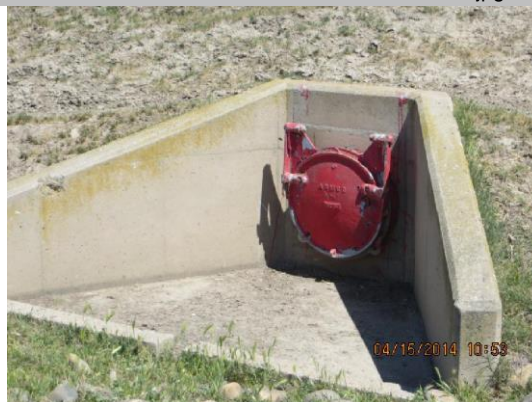
Photo 2 of 3 : UCIP_FA_2020_62039_61008.jpg

Concrete headwall and flapgate at WS toe.

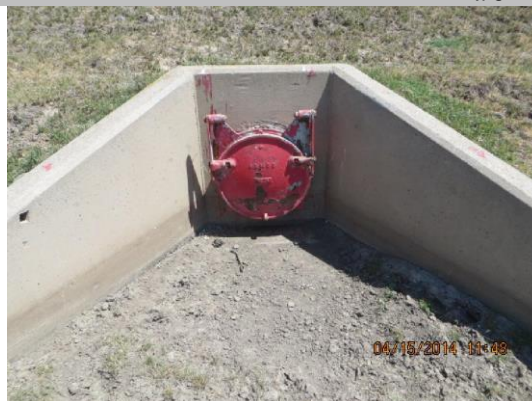
Photo 2 of 3 : UCIP_FA_2020_62040_61010.jpg

Concrete headwall and flapgate on WS toe.

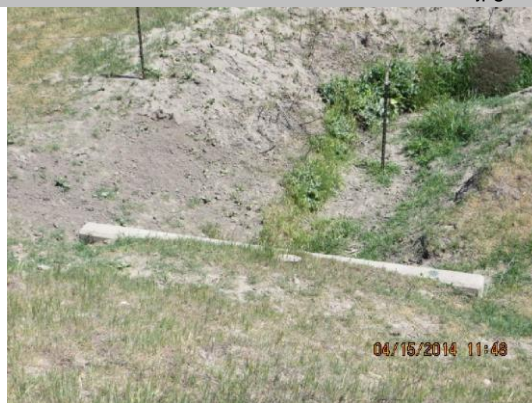
Photo 3 of 3 : UCIP_FA_2020_62040_61012.jpg

Concrete headwall and pipe at LS toe.

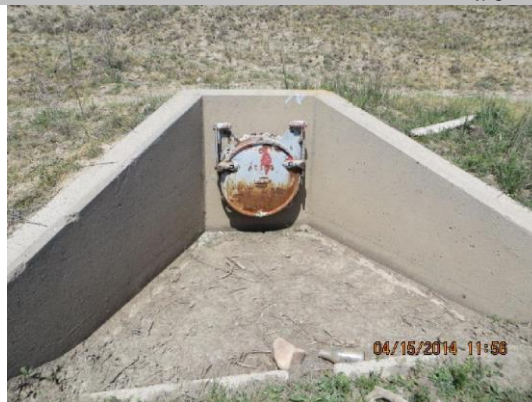
Photo 2 of 3 : UCIP_FA_2020_62041_61015.jpg

Headwall, pipe, and flapgate on WS toe.

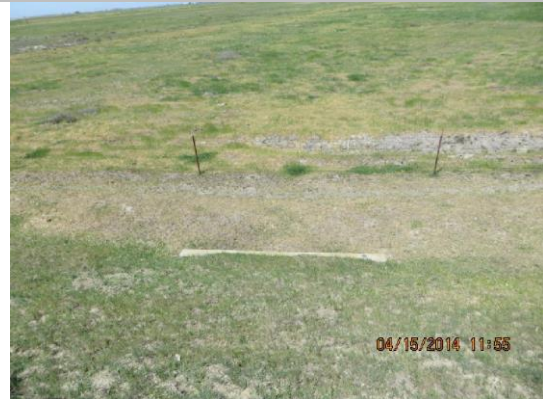
Photo 3 of 3 : UCIP_FA_2020_62041_61017.jpg

Headwall and pipe on LS toe.

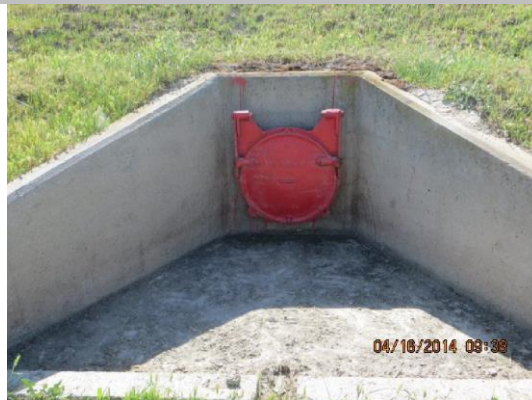
Photo 2 of 3 : UCIP_FA_2020_62046_61067.jpg

Headwall and flapgate on WS toe.

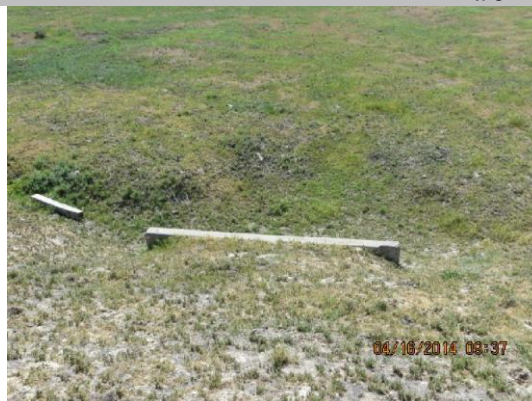
Photo 3 of 3 : UCIP_FA_2020_62046_61069.jpg

Concrete headwall on LS toe.

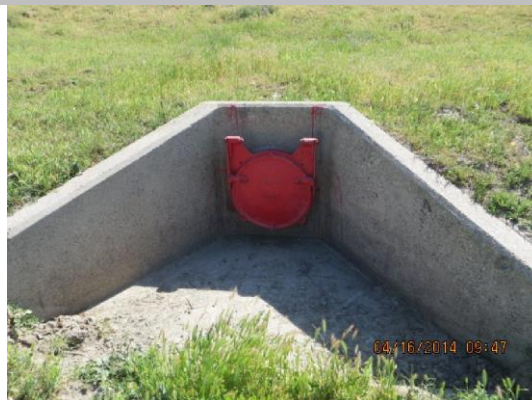
Pipe, flapgate and headwall on WS toe.

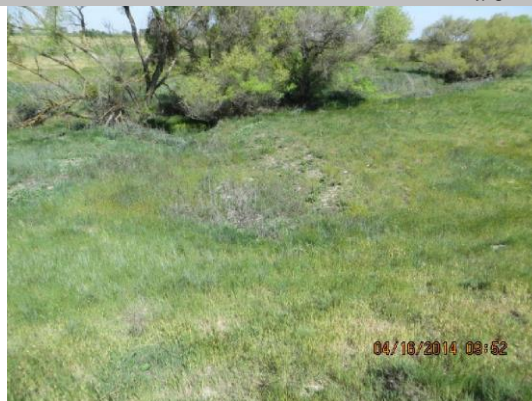
Headwall and flapgate at WS toe.

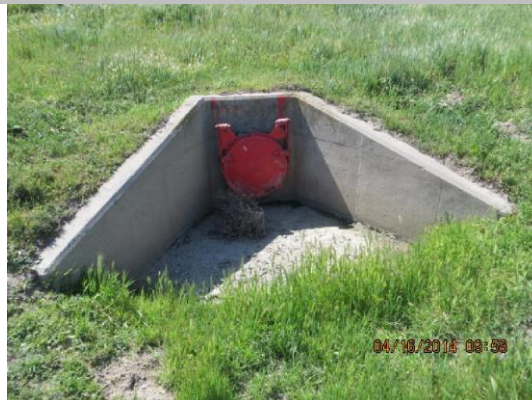
DS_ID:19832
FS_ID:62049
EP_NO: N/A
Repair Type: Non-Urgent
EVAL Issue:
Crossing Status: Found
UCIP Comments: 04/16/2014 Some sediment buildup at inlet on LS toe. (W. Wylie - DWR UCIP)
FIELD_STRUCT_DESC: 24-inch corrugated metal gravity drainage pipe through the levee, 11.5 feet below the crown. Flap gate on the waterside (WS) end. Concrete headwall on each end. [Additional Reference(s): DWR Levee Log, 2002 (HLM 0.88), listed as a 24-inch corrugated metal pipe (CMP). USACE San Joaquin O&M Manual, Unit 601 Part 1 (SJR601.1), 1967, (HLM 0.89), listed as a 24-inch CMP].
FS Date: 4/16/2014

Headwall, pipe, and flapgate on WS toe.

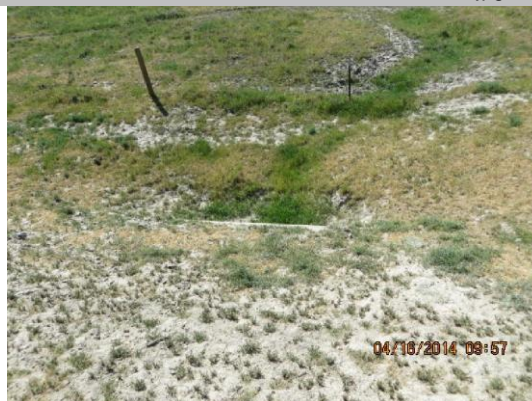
Photo 3 of 3 : UCIP_FA_2020_62049_61085.jpg

Pipe and headwall on LS toe.

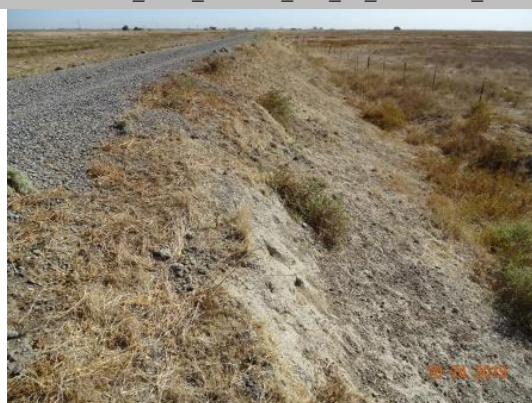
Photo 1 of 1 : FA_2020_NA0010_126_28_20200901_00008.jpg

View of slope damage on the landside of the levee looking upstream.
(Fall 2019)

| A2 : Repair the levee slope damaged by livestock and prevent large animal access. | | | | | |

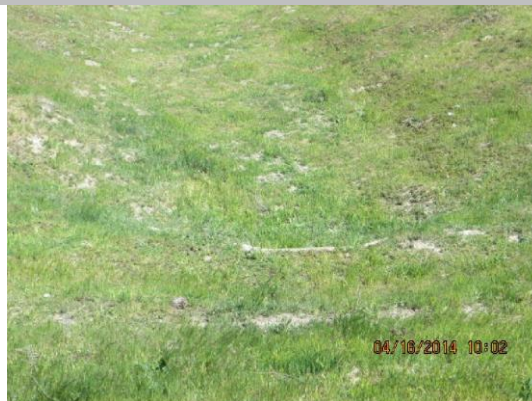
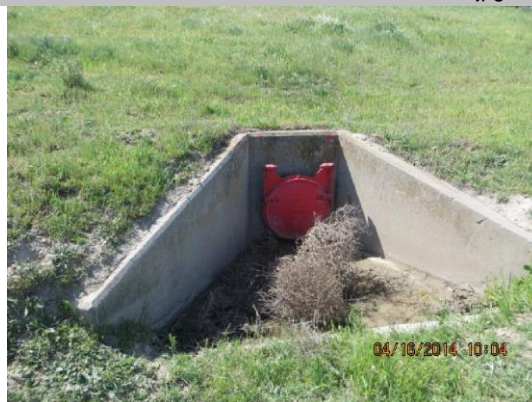
| DS_ID:19833 FS_ID:62050 EP_NO: N/A Repair Type: Non-Urgent EVAL Issue: Crossing Status: Found UCIP Comments: 04/16/2014 Debris blocking landward headwall--recommend clearing. (W. Wylie - DWR UCIP) FIELD_STRUCT_DESC: 24-inch corrugated metal gravity drainage pipe through the levee, 11.6 feet below the crown. Flap gate on the waterside (WS) end. Concrete headwall on each end. [Additional Reference(s): DWR Levee Log, 2002 (HLM 1.20), listed as a 24-inch corrugated metal pipe (CMP). USACE San Joaquin O&M Manual, Unit 601 Part 1 (SJR601.1), 1967, (HLM 1.21), listed as a 24-inch CMP]. FS Date: 4/16/2014 | | | | | | |

Concrete headwall, pipe, and flapgate on WS toe.

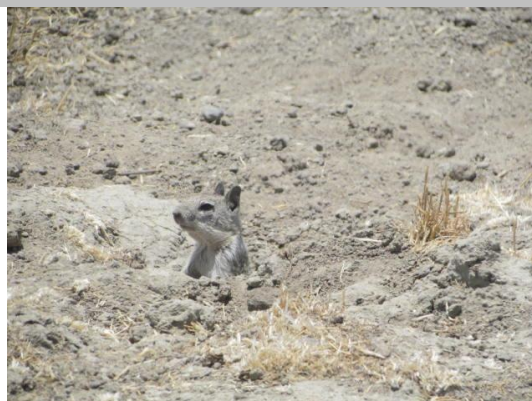
Photo 1 of 1 : FA_2020_NA0010_126_8_20200901_00004.jpg

Looking west at rodent holes on landward slope.

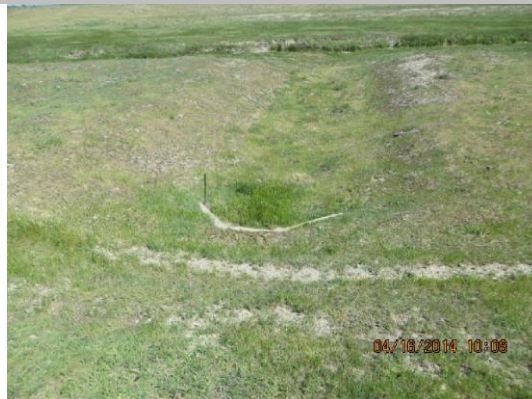
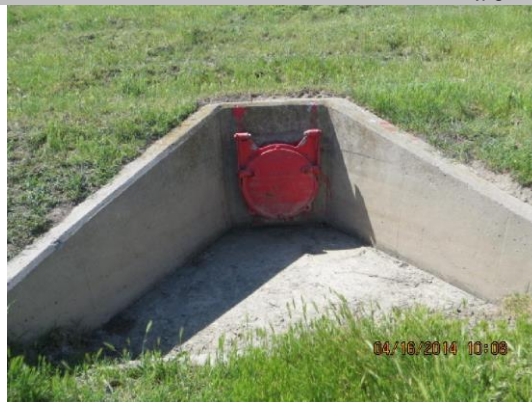
Pipe, headwall, and flapgate on WS toe.

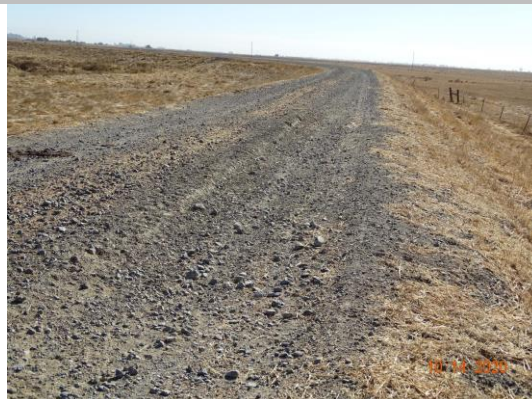
Photo 1 of 1 : FA_2020_NA0010_126_5_20201028_00045.jpg

| A depression is noted on the levee crown. | | | | | |

View of rutting on the levee crown. (Fall 2020)

| C2 : Repair depressions or ruts in the crown or slope. | | | | | |

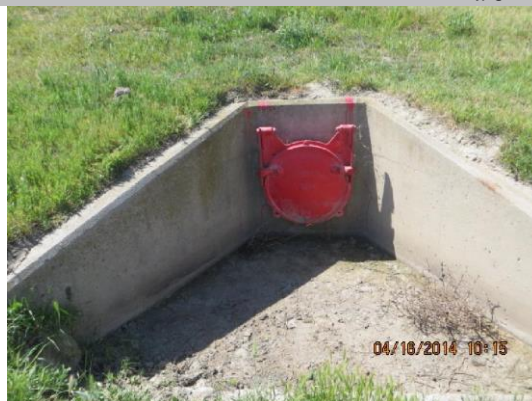
Photo 1 of 3 : UCIP_FA_2020_62052_61098.jpg

Pipe, headwall, and flapgate on WS toe.

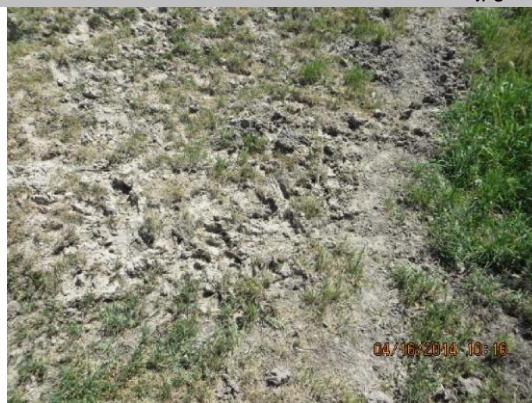
| DS_ID:19835 FS_ID:62052 EP_NO: N/A Repair Type: Non-Urgent EVAL Issue: Crossing Status: Found UCIP Comments: 04/16/2014 Non-functional landward inlet is buried in sediment. Need to contact owner to determine status. (W. Wylie - DWR UCIP) FIELD_STRUCT_DESC: 24-inch corrugated metal gravity drainage pipe through the levee, 12 feet below the crown. Flap gate on the waterside (WS) end. Concrete headwall on each end. [Additional Reference(s): DWR Levee Log, 2002 (HLM 2.04), listed as a 24-inch corrugated metal pipe (CMP). USACE San Joaquin O&M Manual, Unit 601 Part 1 (SJR601.1), 1967, (HLM 2.05), listed as a 24-inch CMP]. FS Date: 4/16/2014 | | | | | | |

Pipe and headwall buried in sediment at LS toe.

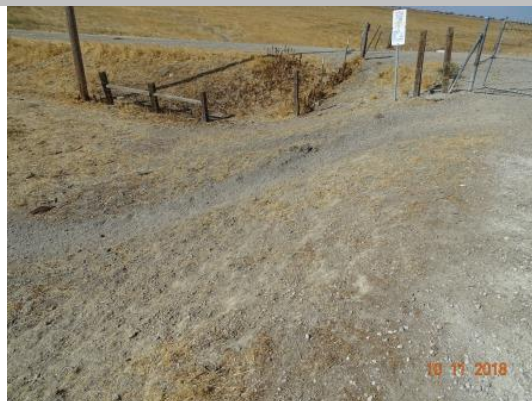
Photo 1 of 1 : FA_2020_NA0010_126_22_20200901_00007.jpg

| There is damage to the slope and shoulder from livestock. | | | | | |

Slope and shoulder damage from livestock. (Fall 2018)

| A2 : Repair the levee slope damaged by livestock and prevent large animal access. | | | | | |

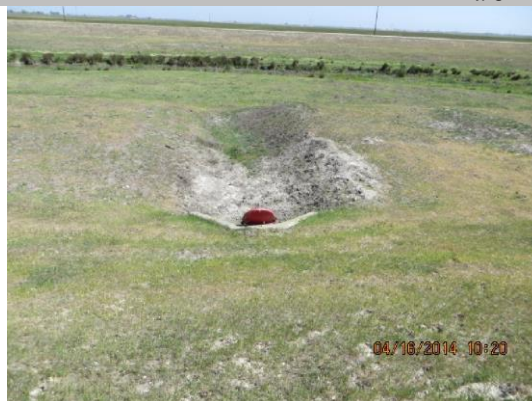
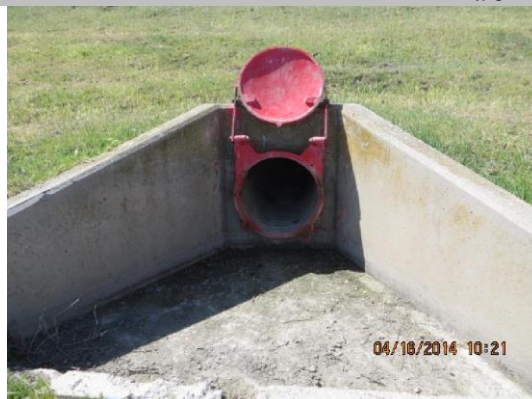
Pipe, headwall, and flapgate on WS toe.

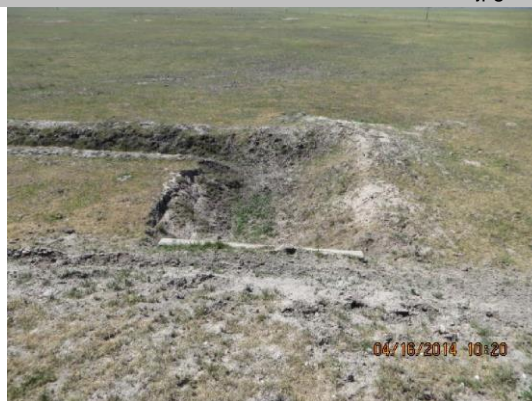
Photo 3 of 3 : UCIP_FA_2020_62053_61101.jpg

| DS_ID:19836 FS_ID:62053 EP_NO: N/A Repair Type: Non-Urgent EVAL Issue: Crossing Status: Found UCIP Comments: 04/16/2014 Sediment buildup in pipe visible from landward side. (W. Wylie - DWR UCIP) FIELD_STRUCT_DESC: 24-inch corrugated metal gravity drainage pipe through the levee, 9.5 feet below the crown. Flap gate on the waterside (WS) end. Concrete headwall on each end. [Additional Reference(s): DWR Levee Log, 2002 (HLM 2.12), listed as a 24-inch corrugated metal pipe (CMP). USACE San Joaquin O&M Manual, Unit 601 Part 1 (SJR601.1), 1967, (HLM 2.12), listed as a 24-inch CMP]. FS Date: 4/16/2014 | | | | | | |

Pipe and headwall on LS toe.

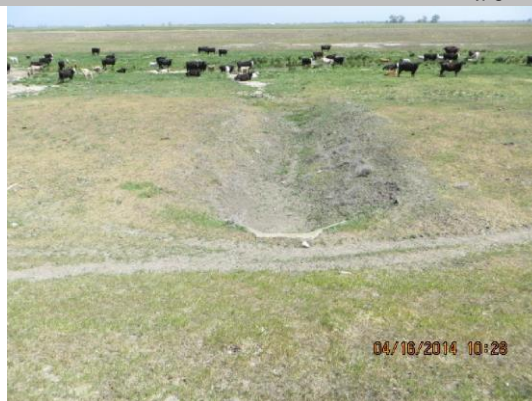
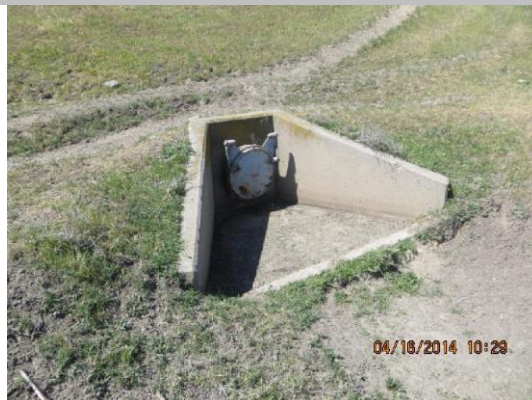
Pipe, headwall, and flapgate on Ws toe.

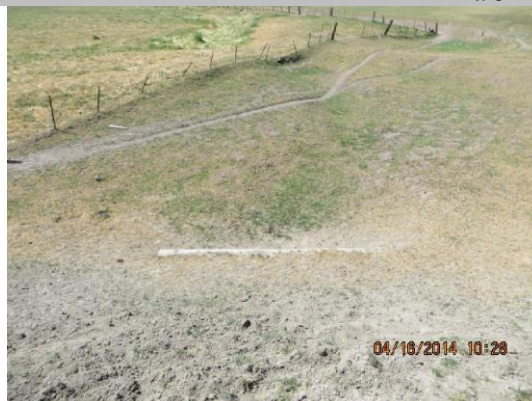
Photo 3 of 3 : UCIP_FA_2020_62054_61106.jpg

Pipe and headwall on LS toe.

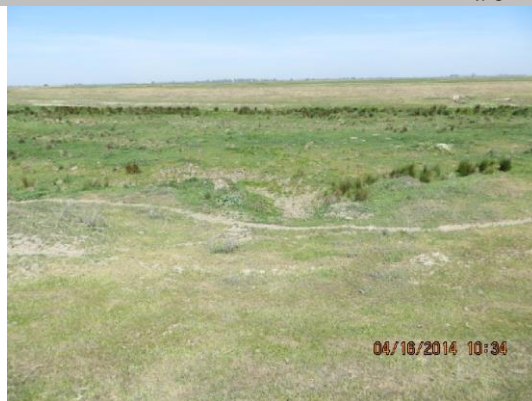
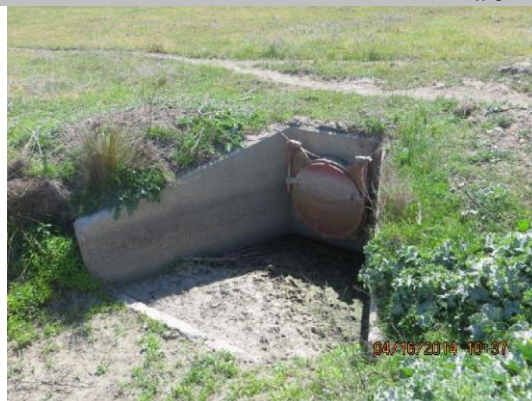
Pipe, headwall, and flapgate on WS toe.

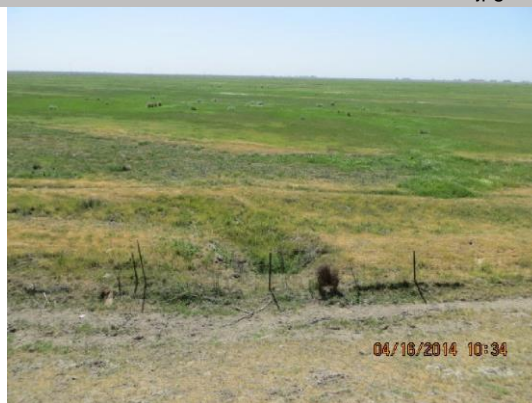
Photo 3 of 3 : UCIP_FA_2020_62058_61111.jpg

DS_ID:19838
 FS_ID:62058
 EP_NO: N/A
 Repair Type: Non-Urgent
 EVAL Issue:
 Crossing Status: Found
 UCIP Comments: 7/20/2016 LS inlet buried under dense vegetation. Dense vegetation limits the inspector's visibility to identify signs of pipe failure (leaks) along the WS and LS slope. Recommend removing vegetation along pipe alignment to conduct proper inspection of structure and appurtenances. (O. Magana - DWR UCIP)4/16/2014 Pipe blocked by silt on LS toe. Flapgate rusty and does not operate correctly. (W. Wylie - DWR UCIP)
 FIELD_STRUCT_DESC: 36-inch corrugated metal gravity drainage pipe through the levee, 13.4 feet below the crown. Flap gate on the waterside (WS) end. Concrete headwall on each end. [Additional Reference(s): DWR Levee Log, 2002 (HLM 3.06), listed as a 36-inch corrugated metal pipe (CMP). USACE San Joaquin O&M Manual, Unit 601 Part 1 (SJR601.1), 1967, (HLM 3.06), listed as a 36-inch CMP].

Pipe and headwall on LS toe.

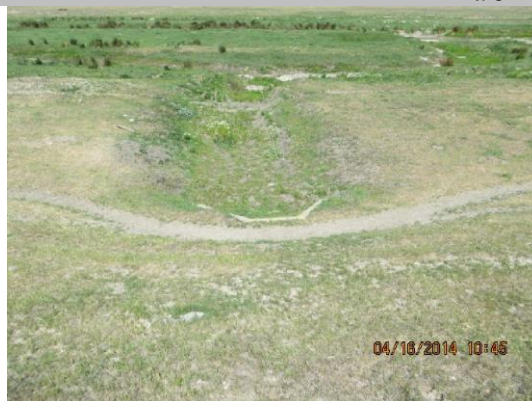
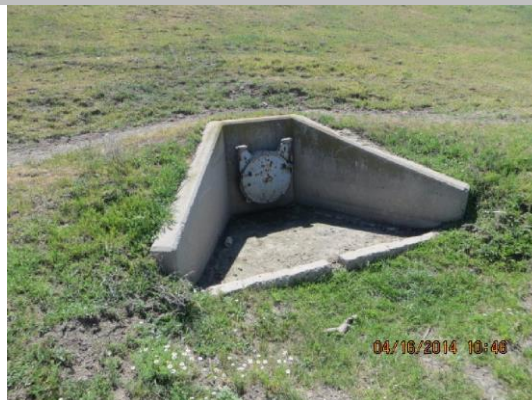
Pipe, flapgate, and headwall on WS toe.

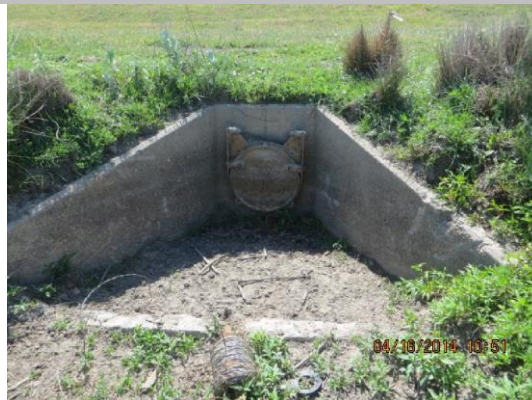
Pipe, headwall, and flapgate on WS toe.

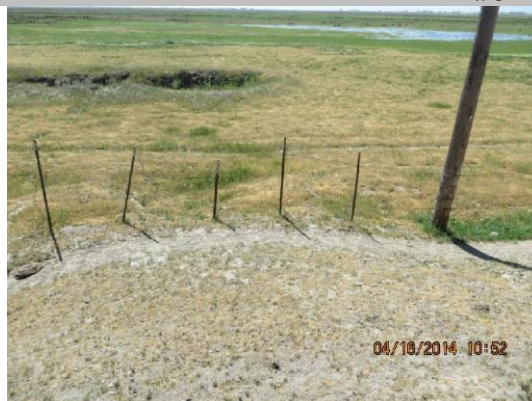
Photo 3 of 3 : UCIP_FA_2020_62057_61132.jpg

DS_ID:19840
FS_ID:62057
EP_NO: N/A
Repair Type: Non-Urgent
EVAL Issue:
Crossing Status: Found
UCIP Comments: 04/16/2014 No access available on landward side. Need to confirm status of crossing. (W. Wylie - DWR UCIP)
FIELD_STRUCT_DESC: 24-inch corrugated metal gravity drainage pipe through the levee, 13 feet below the crown. Flap gate on the waterside (WS) end. Concrete headwall on each end. [Additional Reference(s): DWR Levee Log, 2002 (HLM 3.43), listed as a 24-inch corrugated metal pipe (CMP). USACE San Joaquin O&M Manual, Unit 601 Part 1 (SJR601.1), 1967, (HLM 3.43), listed as a 24-inch CMP].
FS Date: 4/16/2014

Pipe likely at drainage swale off LS toe.

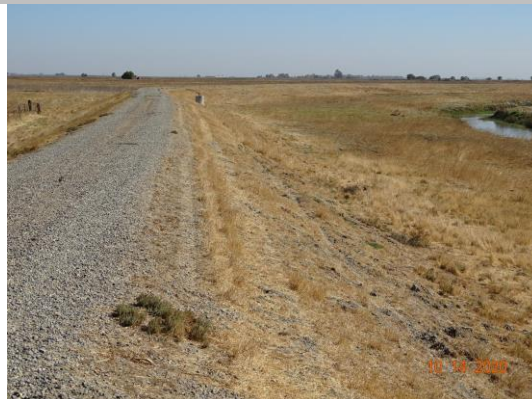
Photo 1 of 1 : FA_2020_NA0010_127_5_20201028_00011.jpg

View of waterside slope looking downstream. (Fall 2020)

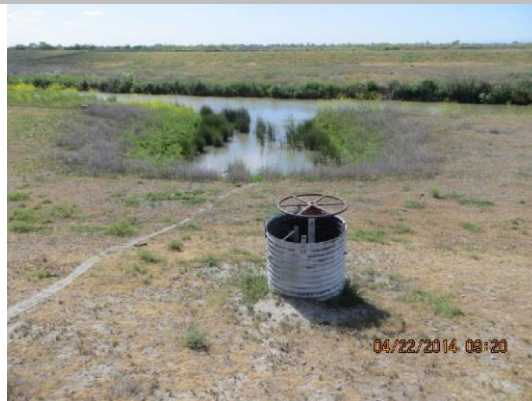
Photo 1 of 3 : UCIP_FA_2020_62059_62119.jpg

| UCIP Comments: 04/22/2014 Concrete headwalls on landward and waterward under water. Need photo to confirm condition of concrete headwalls, pipe, and gate on both toes. (W. Wylie - DWR UCIP) | | | | | | |

Slide gate in CMP riser on WS slope with outlet visible in background.

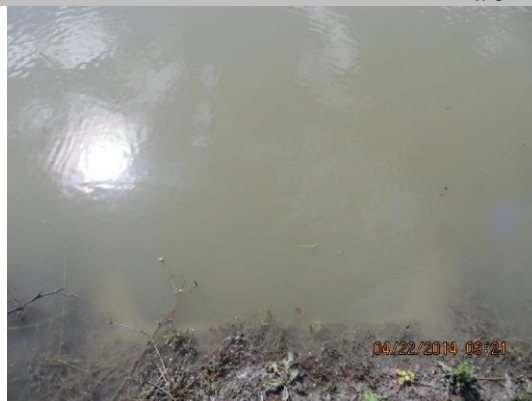
Photo 2 of 3 : UCIP_FA_2020_62059_62117.jpg

Concrete headwall visible under water on WS toe.

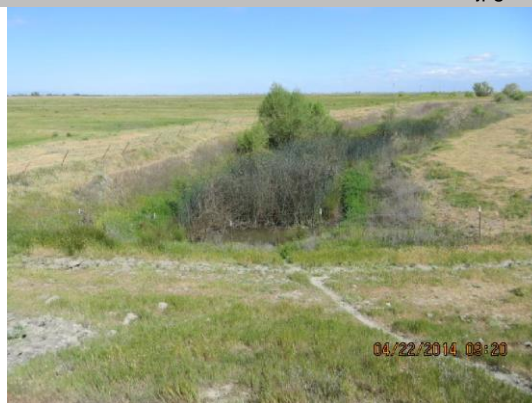
Photo 3 of 3 : UCIP_FA_2020_62059_62118.jpg

Concrete headwall visible at inlet on LS toe.

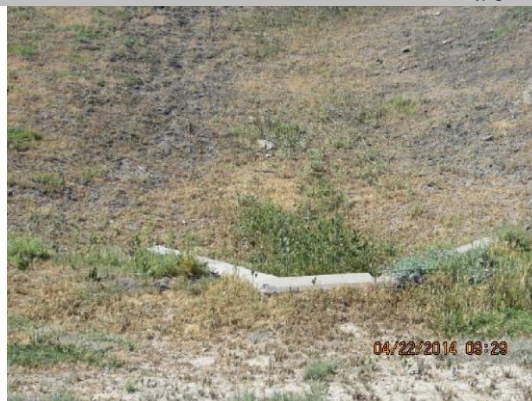
DS_ID:19842
FS_ID:62060
EP_NO: N/A
Repair Type: Non-Urgent
EVAL Issue:
Crossing Status: Found
UCIP Comments: 04/22/2014 Animal burrows in area on LS slope. Minor sediment buildup in pipe visible on landward side--recommend clearing. (W. Wylie - DWR UCIP)
FIELD_STRUCT_DESC: 24-inch corrugated metal gravity drainage pipe through the levee, 8.7 feet below the crown. Flap gate on the waterside (WS) end. Concrete headwall on the landside (LS) end. Concrete U-shaped headwall on the WS end. [Additional Reference(s): DWR Levee Log, 2002 (HLM 0.70), listed as a 24-inch corrugated metal pipe (CMP). USACE San Joaquin O&M Manual, Unit 601 Part 1 (SJR601.1), 1967, (HLM 0.70), listed as a 24-inch CMP].
FS Date: 4/22/2014

Headwall, flapgate, and pipe on WS toe.

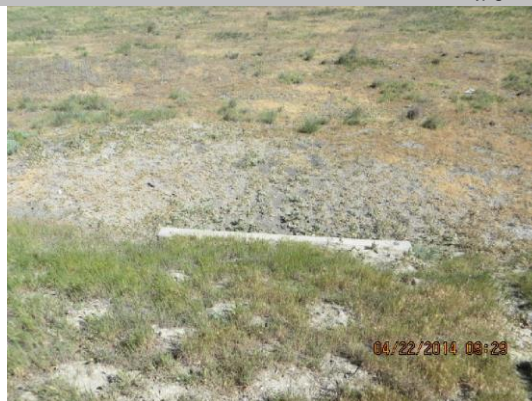
Photo 3 of 3 : UCIP_FA_2020_62060_62129.jpg

Headwall and pipe on LS toe.

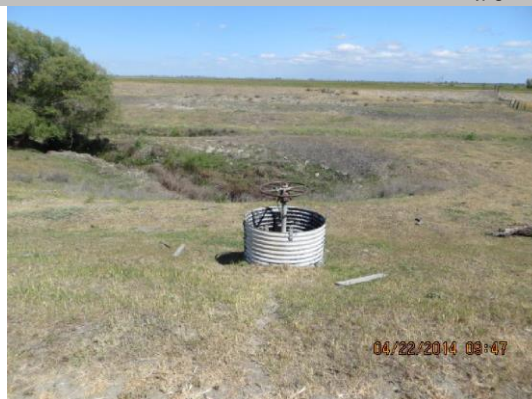
Photo 1 of 3 : UCIP_FA_2020_62062_62144.jpg

| DS_ID:19845 FS_ID:62062 EP_NO: N/A Repair Type: Non-Urgent EVAL Issue: Crossing Status: Found UCIP Comments: 04/22/2014 Inlet blocked at LS toe by wooden gate. Need to contact owner to determine status. (W. Wylie - DWR UCIP) FIELD_STRUCT_DESC: 36-inch corrugated metal gravity drainage pipe through the levee, 19.6 feet below the crown. Slide gate in a 48-inch corrugated metal pipe (CMP) riser on the waterside (WS) slope. Concrete U-shaped headwall on each end. [Additional Reference(s): DWR Levee Log, 2002 (HLM 0.31), listed as a 24-inch corrugated metal pipe (CMP). USACE San Joaquin O&M Manual, Unit 601 Part 1 (SJR601.1), 1967, (HLM 0.31), listed as a 24-inch CMP]. FS Date: 4/22/2014 | | | | | | |

Headwall and pipe visible on LS toe. Slide gate inside 48-inch CMP riser on WS slope.

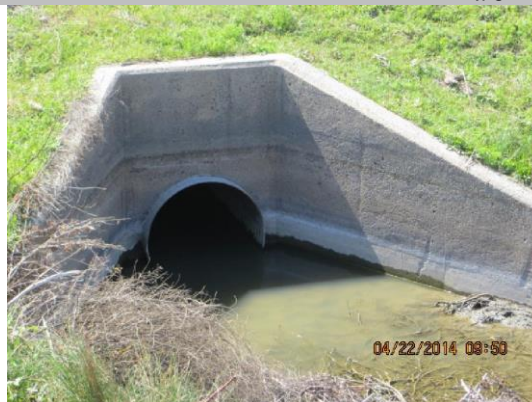
Photo 2 of 3 : UCIP_FA_2020_62062_62146.jpg

Headwall and pipe on WS toe.

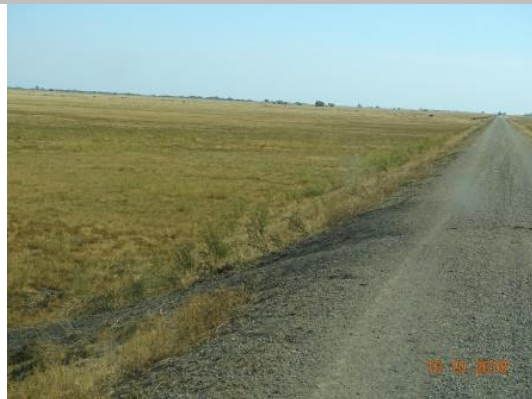
Photo 1 of 1 : FA_2020_NA0010_129_11_20200901_00003.jpg

| Damage is from livestock on the landside slope. | | | | | |

View of slope damage on landside. (Fall 2018)

| A2 : Repair the levee slope damaged by livestock and prevent large animal access. | | | | | |

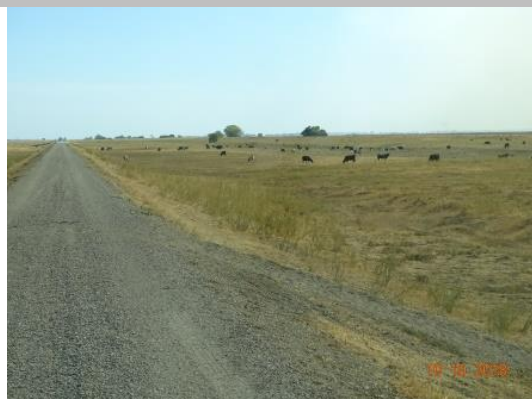
Photo 1 of 1 : FA_2020_NA0010_129_13_20200901_00006.jpg

| Damage to the levee slope from livestock traffic. | | | | | |

View of damage on waterside shoulder and slope. (Fall 2018)

| A2 : Repair the levee slope damaged by livestock and prevent large animal access. | | | | | |

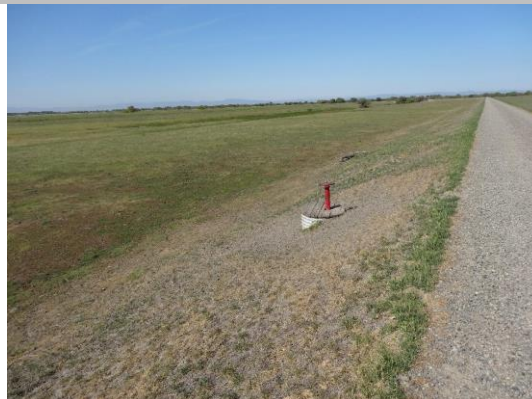
Photo 1 of 3 : UCIP_FA_2020_62063_66644.jpg

| DS_ID:19846 FS_ID:62063 EP_NO: N/A Repair Type: Non-Urgent EVAL Issue: Crossing Status: Found UCIP Comments: 04/18/2014 Need to contact owner. Recommend clearing sediment deposit inside pipe. (O. Magana - DWR UCIP) FIELD_STRUCT_DESC: 24-inch corrugated metal gravity drainage pipe through the levee, 11 feet below the crown. Slide gate in a corrugated metal pipe (CMP) riser on the waterside (WS) end. [Additional Reference(s): DWR Levee Log, 2002 (HLM 0.43), listed as a 24-inch corrugated metal pipe (CMP). USACE San Joaquin O&M Manual, Unit 601 Part 1 (SJR601.1), 1967, (HLM 0.42), listed as a 24-inch CMP]. FS Date: 4/18/2014 | | | | | | |

View of slide gate inside CMP riser located on waterward slope.

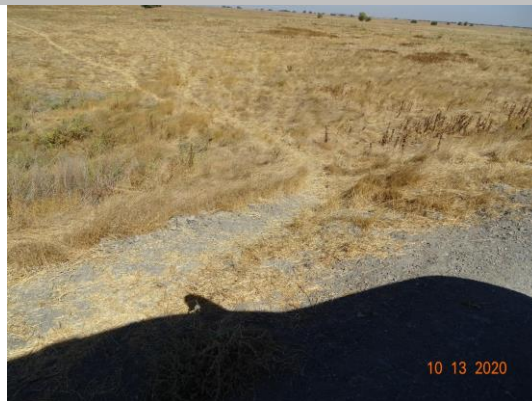
Photo 1 of 1 : FA_2020_NA0010_129_9_20201028_00031.jpg

View of livestock trail on the landside slope. (Fall 2020)

| A2 : Repair the levee slope damaged by livestock and prevent large animal access. | | | | | |

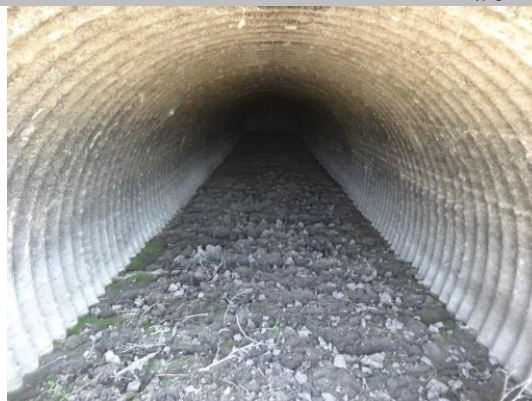
Photo 3 of 3 : UCIP_FA_2020_62067_62016.jpg

| DS_ID:19850 FS_ID:62067 EP_NO: N/A Repair Type: Non-Urgent EVAL Issue: Crossing Status: Found UCIP Comments: 04/18/2014 Need to contact owner. Recommend clearing sediment deposit inside pipe. (O. Magana - DWR UCIP) FIELD_STRUCT_DESC: 48-inch corrugated metal gravity drainage pipe through the levee, 16.3 feet below the crown. Slide gate in a pipe riser on the waterside (WS) slope. [Additional Reference(s): DWR Levee Log, 2002 (HLM 1.50), listed as a 48-inch corrugated metal pipe (CMP). USACE San Joaquin O&M Manual, Unit 601 Part 1 (SJR601.1), 1967, (HLM 1.50), listed as a 48-inch CMP]. FS Date: 4/18/2014 | | | | | |

Inside view of pipe from waterward side--sediment build up.

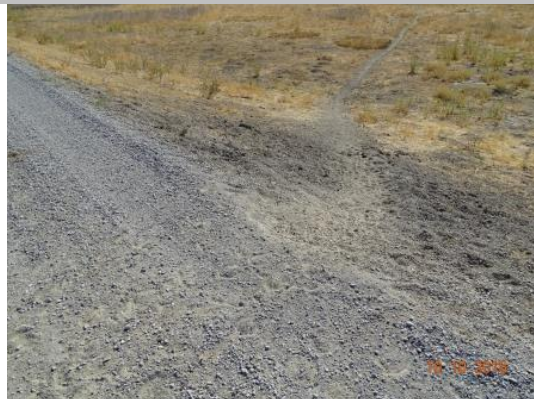
Photo 2 of 2 : FA_2020_NA0010_129_12_20200901_00005.jpg

| Damage is from livestock to both landside and waterside slopes. | | | | | |

View of waterside slope. (Fall 2018)

| A2 : Repair the levee slope damaged by livestock and prevent large animal access. | | | | | |

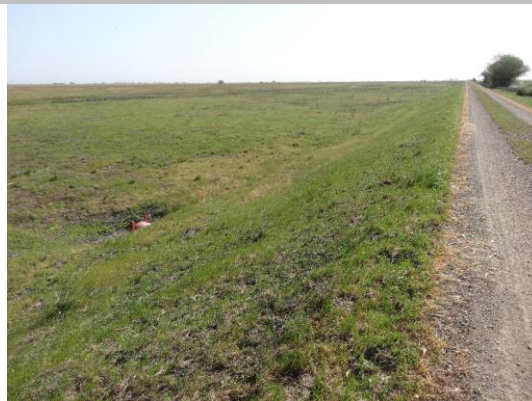
Photo 1 of 3 : UCIP_FA_2020_62073_62048.jpg

DS_ID:19856
 FS_ID:62073
 EP_NO: N/A
 Repair Type: Non-Urgent
 EVAL Issue:
 Crossing Status: Found
 UCIP Comments: 04/18/2014 Need to contact owner. Recommend clearing sediment deposit inside pipe. (O. Magana - DWR UCIP)
 FIELD_STRUCT_DESC: 24-inch corrugated metal gravity drainage pipe through the levee, 10.5 feet below the crown. Flap gate on the waterside (WS) end. [Additional Reference(s): DWR Levee Log, 2002 (HLM 1.06), listed as a 24-inch corrugated metal pipe (CMP). USACE San Joaquin O&M Manual, Unit 601 Part 1 (SJR601.1), 1967, (HLM 1.06), listed as a 24-inch CMP].
 FS Date: 4/18/2014

View of waterward side.

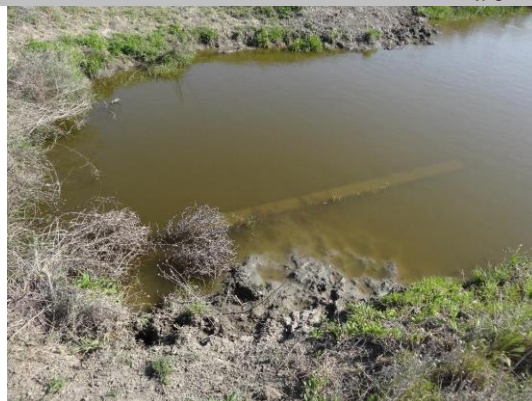
Photo 3 of 3 : UCIP_FA_2020_62074_66653.jpg

DS_ID:19857
FS_ID:62074
EP_NO: N/A
Repair Type: Non-Urgent
EVAL Issue:
Crossing Status: Found
UCIP Comments: 04/18/2014 Landward side not accessible due to dense vegetation and fence. Concrete headwall and flap gate under water therefore not able to evaluate condition. Will need to coordinate with owner to evaluate condition of crossing on waterward side and obtain access to evaluate landward side. (O. Magana - DWR UCIP)
FIELD_STRUCT_DESC: 24-inch corrugated metal gravity drainage pipe through the levee, 17.4 feet below the crown. Flap gate on the waterside (WS) end. [Additional Reference(s): DWR Levee Log, 2002 (HLM 1.28), listed as a 24-inch corrugated metal pipe (CMP). USACE San Joaquin O&M Manual, Unit 601 Part 1 (SJR601.1), 1967, (HLM 1.27), listed as a 24-inch CMP].
FS Date: 4/18/2014

View of concrete wall underwater.

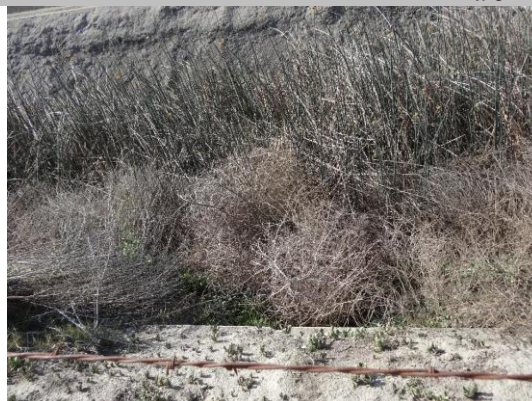
Photo 3 of 3 : UCIP_FA_2020_62076_62062.jpg

| DS_ID:19859 FS_ID:62076 EP_NO: N/A Repair Type: Non-Urgent EVAL Issue: Crossing Status: Found UCIP Comments: 04/18/2014 Need to contact owner. Recommend clearing vegetation from landward side--headwall blocked. (O. Magana - DWR UCIP) FIELD_STRUCT_DESC: 24-inch corrugated metal gravity drainage pipe through the levee, 14.4 feet below the crown. Flap gate on the waterside (WS) end. [Additional Reference(s): DWR Levee Log, 2002 (HLM 2.16), listed as a 24-inch corrugated metal pipe (CMP). USACE San Joaquin O&M Manual, Unit 601 Part 1 (SJR601.1), 1967, (HLM 2.16), listed as a 24-inch CMP]. FS Date: 4/18/2014 | | | | | | |

Dense vegetation on landward side--limited access due to fence along landward side.

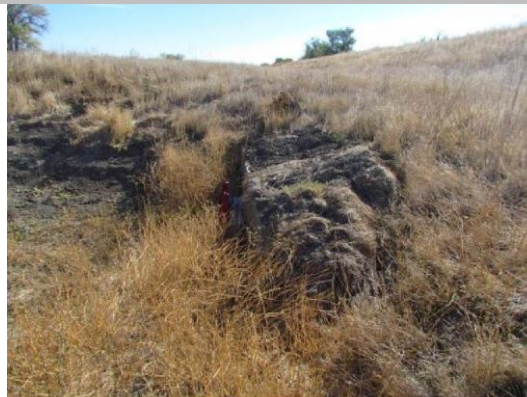
Photo 2 of 3 : UCIP_FA_2020_62078_74729.jpg

Repair to headwall located on waterward side has been addressed.

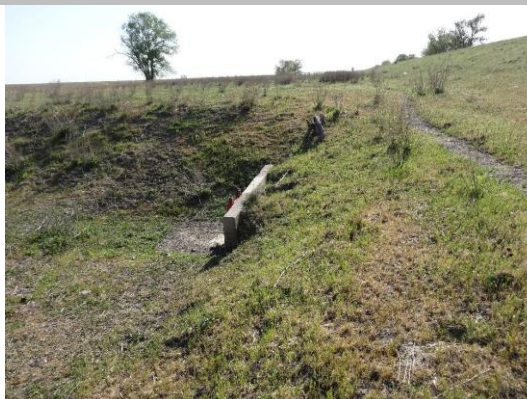
Photo 3 of 3 : UCIP_FA_2020_62078_62072.jpg

Side view of concrete headwall which appears to be slightly slanted forward--missing soil behind headwall.

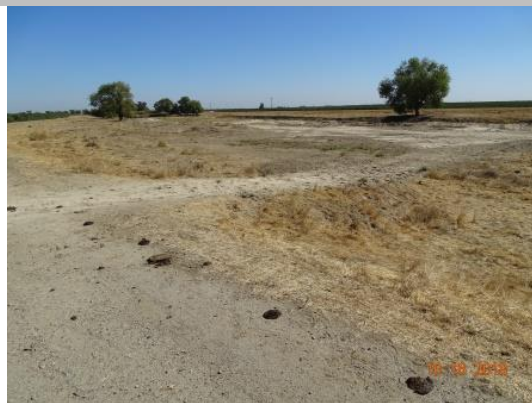
Photo 1 of 1 : FA_2020_NA0010_131_5_20200901_00002.jpg

| There is an unauthorized ramp on waterside slope. | | | | | |

Unauthorized ramp constructed on the waterside slope.

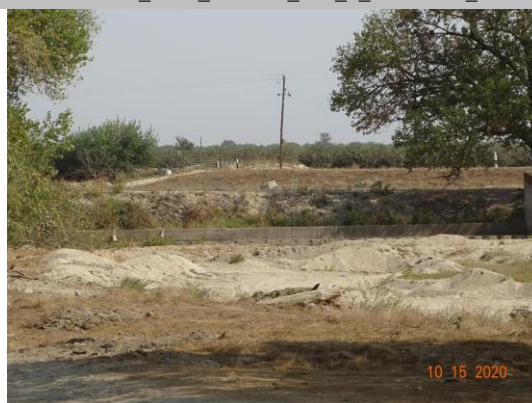
Photo 1 of 1 : FA_2020_NA0010_131_6_20201109_00012.jpg

| Sand dam may have been blown out due to high flows in 2017 but has been restored. The sand dam referenced in this issue is an unauthorized construction in the channel by the landowner. It blocks the entire channel. | | | | | |

Downstream view of sand dam constructed upstream of the Ash Slough Drop Structure 4. (Fall 2020)

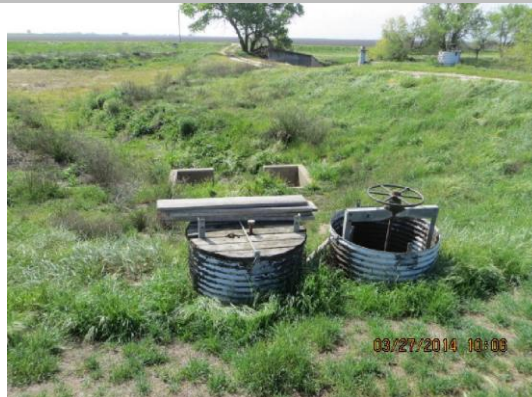
Photo 1 of 3 : UCIP_FA_2020_62080_59385.jpg

DS_ID:19727
FS_ID:62080
EP_NO: N/A
Repair Type: Non-Urgent
EVAL Issue:
Crossing Status: Found
UCIP Comments: 03/27/2014 Appears abandoned and if so should be done so properly. Pipe filled with soil on WS at outlet. Actuator missing from slide gate on WS shoulder. (W. Wylie - DWR UCIP)
FIELD_STRUCT_DESC: [Rounder Irrigation Structure] 1 of 2: 36-inch corrugated metal gravity drainage pipe through the levee, 12.3 feet below the crown. Slide gate in a 48-inch corrugated metal pipe (CMP) riser on the waterside (WS) slope. 6-foot by 12-foot concrete distribution box on the landside (LS). 7-foot by 14-foot concrete outlet structure on the WS toe. [Additional Reference(s): DWR Levee Log, 2002 (HLM 1.14), listed as a 36-inch corrugated metal pipe (CMP). USACE San Joaquin O&M Manual, Unit 601 Part 1 (SJR601.1), 1967, (HLM 1.14), listed as a 36-inch CMP].
FS Date: 3/27/2014

Slide gate in CMP riser on WS shoulder.

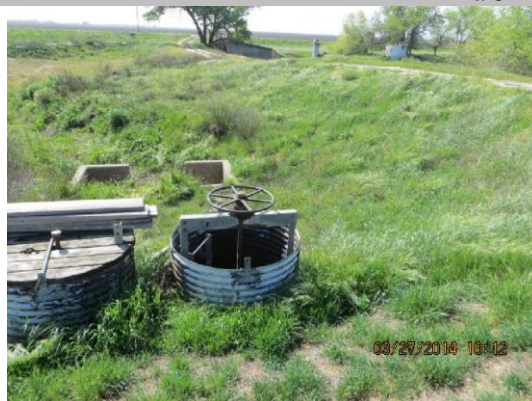
Photo 1 of 3 : UCIP_FA_2020_62081_59390.jpg

DS_ID:19908
 FS_ID:62081
 EP_NO: N/A
 Repair Type: Non-Urgent
 EVAL Issue:
 Crossing Status: Found
 UCIP Comments: 03/27/2014 No lid on riser at WS shoulder could be safety issue. (W. Wylie - DWR UCIP)
 FIELD_STRUCT_DESC: [Rounder Irrigation Structure] 2 of 2: 36-inch corrugated metal gravity drainage pipe through the levee, 12.3 feet below the crown. Slide gate in a 48-inch corrugated metal pipe (CMP) riser on the waterside (WS) slope. 6-foot by 12-foot concrete distribution box on the landside (LS). 7-foot by 14-foot concrete outlet structure on the WS toe. [Additional Reference(s): DWR Levee Log, 2002 (HLM 1.14), listed as a 36-inch corrugated metal pipe (CMP). USACE San Joaquin O&M Manual, Unit 601 Part 1 (SJR601.1), 1967, (HLM 1.14), listed as a 36-inch CMP].
 FS Date: 3/27/2014

Slide gate in CMP riser without lid on WS shoulder.

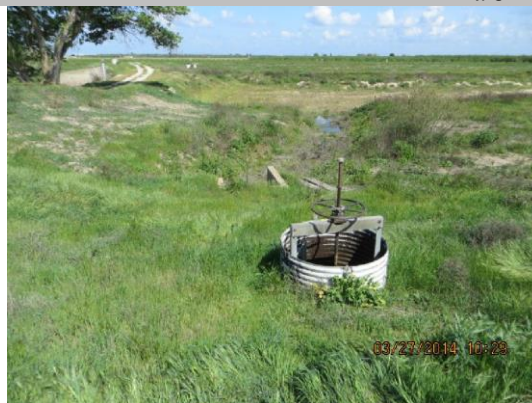
Photo 1 of 3 : UCIP_FA_2020_62082_59398.jpg

| DS_ID:19909 FS_ID:62082 EP_NO: N/A Repair Type: Non-Urgent EVAL Issue: Crossing Status: Found UCIP Comments: 03/27/2014 Lid should be installed on CMP riser on WS slope, could be a safety hazard. Also dense vegetation limits the inspector's visibility to identify signs of pipe failure (leaks) along the slope. Recommend removing vegetation along pipe alignment to conduct proper inspection of structure. (O. Magana - DWR UCIP) FIELD_STRUCT_DESC: [Rounder Irrigation Structure] 36-inch corrugated metal gravity irrigation pipe through the levee, 10 feet below the crown. Slide gate in a 48-inch corrugated metal pipe (CMP) riser on the waterside (WS) slope. 6-foot by 7-foot concrete distribution box at the WS toe. Slots for wooden flashboards on the WS of the box. 7-foot by 9-foot concrete distribution box on the landside (LS), 20 feet from the toe. [Additional Reference(s): DWR Levee Log, 2002 (HLM 1.15), listed as a 36-inch corrugated metal pipe (CMP). USACE San Joaquin O&M Manual, Unit 601 Part 1 (SJR601.1), 1967, (HLM 1.15), listed as a 36-inch CMP]. FS Date: 3/27/2014 | | | | | |

Slide gate in CMP riser and outlet/inlet structure visible in background at WS toe.

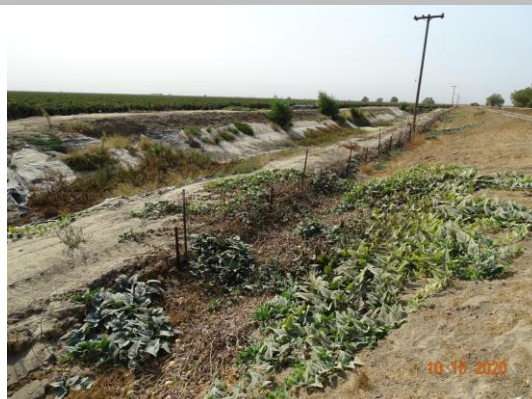
Photo 1 of 1 : FA_2020_NA0010_132_3_20201109_00009.jpg

| Retention pond dug approx. 20 feet from landside toe. | | | | | |

Retention basin dug approximately 20 ft from the landside toe. (Fall 2020)

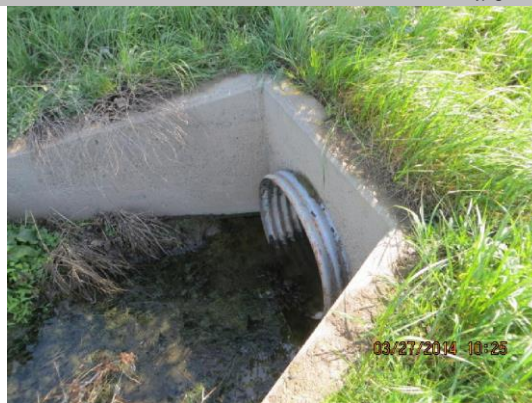
Photo 1 of 3 : UCIP_FA_2020_62083_59402.jpg

Concrete U-shaped headwall on WS toe.

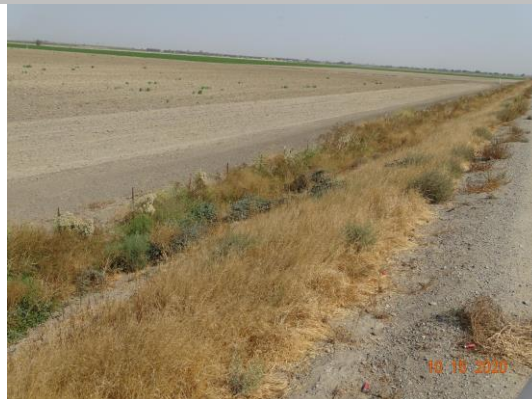
Photo 1 of 1 : FA_2020_NA0010_133_4_20201109_00010.jpg

View of vegetation on the landside slope. (Fall 2020)

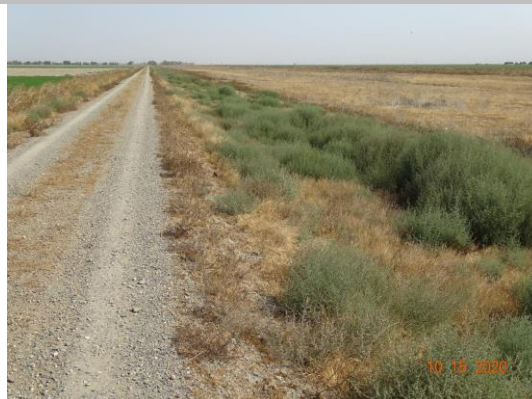
Photo 1 of 1 : FA_2020_NA0010_133_5_20201109_00011.jpg

View of the waterside slope looking upstream. (Fall 2020)
