Flood Control Project Maintenance Levee Inspections

Fall 2020 Levee Maintenance Deficiency Summary Report

San Joaquin River Basin

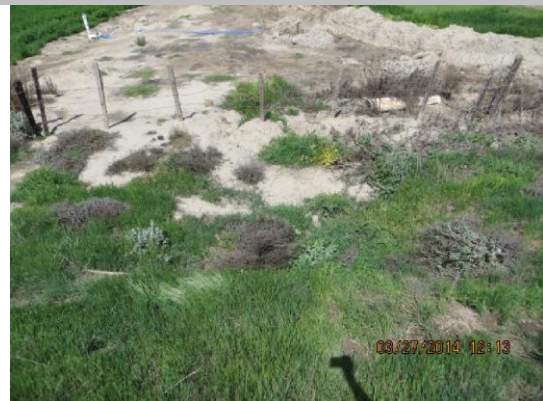
Photo 3 of 3 : UCIP_FA_2020_62085_59451.jpg

DS_ID:19912
 FS_ID:62085
 EP_NO: N/A
 Repair Type: Non-Urgent
 EVAL Issue:
 Crossing Status: Found
 UCIP Comments: 03/27/2014 Dense vegetation limits the inspector's visibility to identify signs of pipe failure (leaks) along the landward slope. Recommend removing vegetation along pipe alignment to conduct proper inspection of structure. (W. Wylie - DWR UCIP)
 FIELD_STRUCT_DESC: 30-inch by 30-inch square reinforced concrete box gravity drainage culvert through the levee, 8.5 feet below the crown. Flap gate on the waterside (WS) end. Concrete headwall on the landside (LS) end. Concrete U-shaped headwall on the WS end.
 [Additional Reference(s): DWR Levee Log, 2002 (HLM 1.01), listed as a 30-inch square reinforced concrete box culvert (RCBC). USACE San Joaquin O&M Manual, Unit 601 Part 1 (SJR601.1), 1967, (HLM 1.01), listed as a 2.5-feet by 2.5-feet RCBC].
 FS Date: 3/27/2014

Concrete headwall on LS toe.

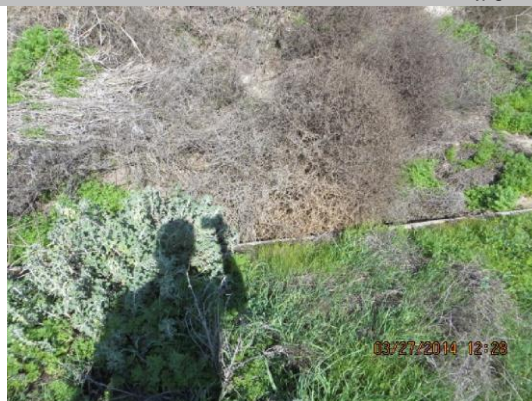
Photo 3 of 3 : UCIP_FA_2020_62086_59455.jpg

DS_ID:19913
FS_ID:62086
EP_NO: N/A
Repair Type: Non-Urgent
EVAL Issue:
Crossing Status: Found
UCIP Comments: 03/27/2014 Excessive vegetation at inlet on LS toe.
(W. Wylie - DWR UCIP)
FIELD_STRUCT_DESC: 30-inch by 30-inch square reinforced concrete box gravity drainage culvert through the levee, 8.9 feet below the crown. Flap gate on the waterside (WS) end. Concrete headwall on the landside (LS) end. Concrete U-shaped headwall on the WS end.
[Additional Reference(s): DWR Levee Log, 2002 (HLM 1.54), listed as a 30-inch square reinforced concrete box culvert (RCBC). USACE San Joaquin O&M Manual, Unit 601 Part 1 (SJR601.1), 1967, (HLM 1.53), listed as a 2.5-feet by 2.5-feet RCBC].
FS Date: 3/27/2014

Concrete headwall on LS toe. Note excessive vegetation buildup.

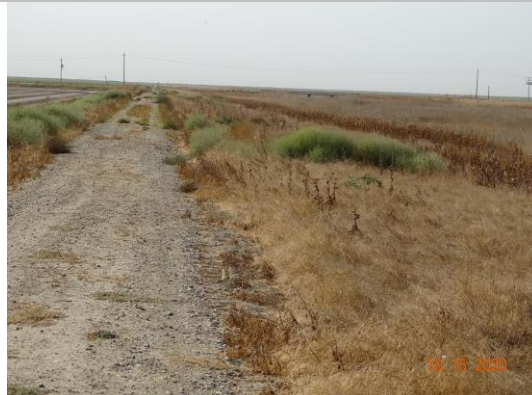
Photo 1 of 1 : FA_2020_NA0010_134_6_20201109_00007.jpg

Looking downstream along the waterside slope. (Fall 2020)

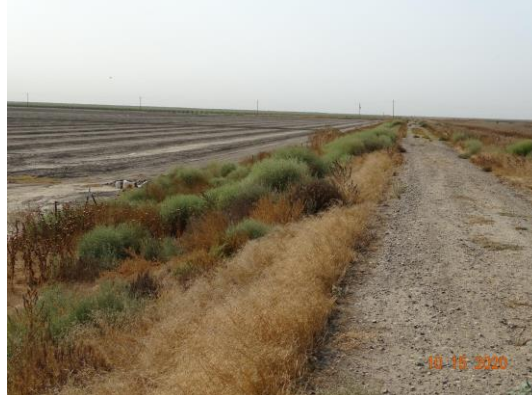
Photo 1 of 1 : FA_2020_NA0010_134_5_20201109_00008.jpg

View of the landside slope looking upstream. (Fall 2020)

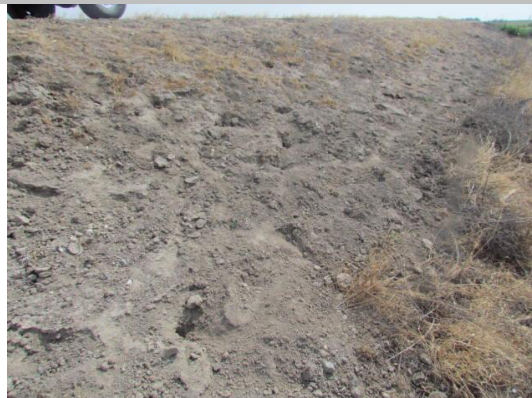
Photo 1 of 1 : FA_2020_NA0010_134_92_20200901_00003.jpg

| Several rodent holes are identified within this section. | | | | | |

Looking at several rodent holes on landward slope.

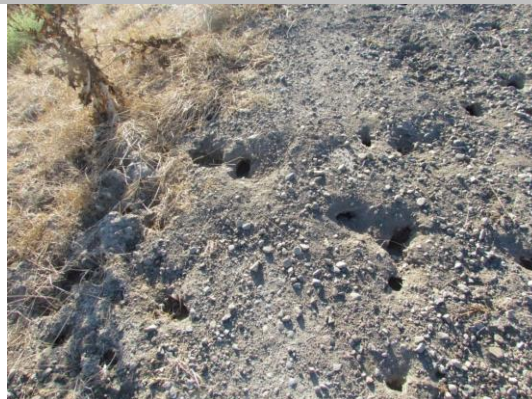
Photo 1 of 1 : FA_2020_NA0010_134_3_20200901_00002.jpg

| Several rodent holes are identified on the levee crown. | | | | | |

Looking at several rodent holes and mole holes on levee crown.

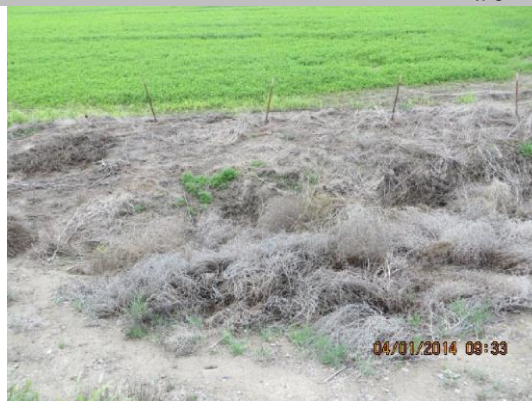
Photo 3 of 3 : UCIP_FA_2020_62089_59682.jpg

| DS_ID:19915 FS_ID:62089 EP_NO: N/A Repair Type: Non-Urgent EVAL Issue: Crossing Status: Found UCIP Comments: 04/01/2014 Dense vegetation buildup at landside toe--recommend clearing. (W. Wylie - DWR UCIP) FIELD_STRUCT_DESC: 30-inch by 30-inch square reinforced concrete box gravity drainage culvert through the levee, 8.5 feet below the crown. Two concrete cutoff walls. Flap gate on the waterside (WS) end. Concrete headwall on the landside (LS) end. Concrete U-shaped headwall on the WS end. [Additional Reference(s): DWR Levee Log, 2002 (HLM 1.46), listed as a 30-inch square reinforced concrete box culvert (RCBC). USACE San Joaquin O&M Manual, Unit 601 Part 1 (SJR601.1), 1967, (HLM 1.46), listed as a 2.5-feet by 2.5-feet RCBC]. FS Date: 4/1/2014 8:12:00 AM | | | | | | |

Concrete headwall on LS toe covered in vegetation/tumble weeds.

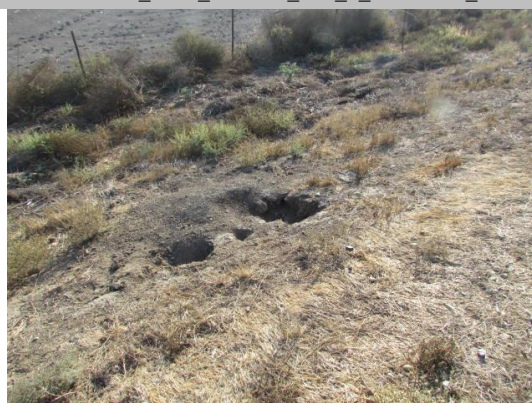
Photo 1 of 1 : FA_2020_NA0010_134_2_20200901_00001.jpg

| Large rodent holes are on the landside slope. | | | | | |

Looking southwest at several rodent holes on landward slope.

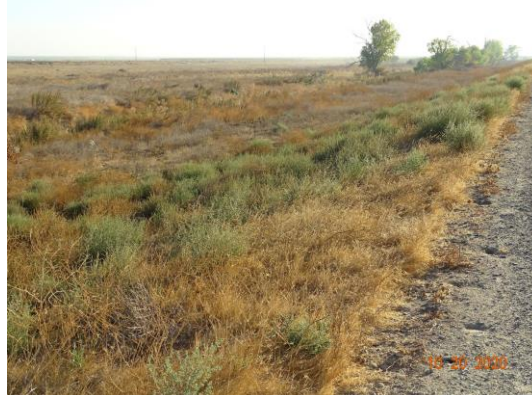
Photo 1 of 1 : FA_2020_NA0010_135_12_20201109_00030.jpg

View of the landside slope looking upstream. (Fall 2020)

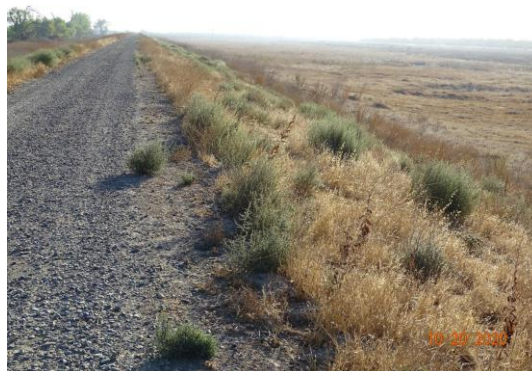
Photo 1 of 1 : FA_2020_NA0010_135_13_20201109_00031.jpg

Looking upstream along the waterside slope. (Fall 2020)

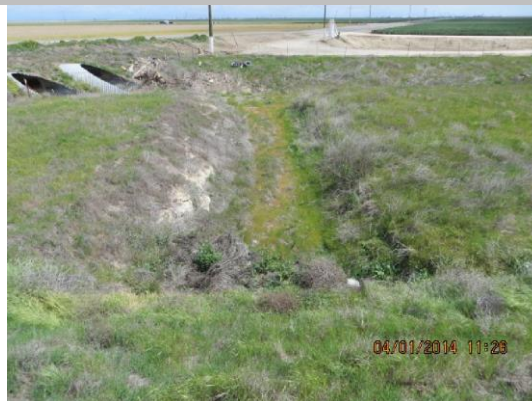
Photo 3 of 3 : UCIP_FA_2020_62099_59709.jpg

| DS_ID:19916 FS_ID:62099 EP_NO: N/A Repair Type: Non-Urgent EVAL Issue: Crossing Status: Found UCIP Comments: 04/01/2014 Dense vegetation limits the inspector's visibility to identify signs of pipe failure (leaks) along the landward slope. Recommend removing vegetation along pipe alignment to conduct proper inspection of structure. (W. Wylie - DWR UCIP) FIELD_STRUCT_DESC: 48-inch by 60-inch reinforced concrete box gravity drainage culvert through the levee, 14.6 feet below the crown. Flap gate on the waterside (WS) end. Concrete headwall on the landside (LS) end. Concrete U-shaped headwall on the WS end. [Additional Reference(s): DWR Levee Log, 2002 (HLM 2.58), listed as a 48-inch by 60-inch reinforced concrete box culvert (RCBC). USACE San Joaquin O&M Manual, Unit 601 Part 1 (SJR601.1), 1967, (HLM 2.58), listed as a 5-feet by 4-feet RCBC]. FS Date: 4/1/2014 | | | | | | |

Concrete headwall at LS toe.

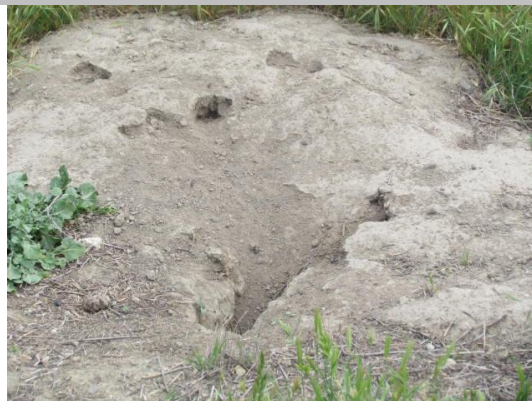
Photo 1 of 1 : FA_2020_NA0010_135_8_20200901_00004.jpg

| Multiple rodent holes are noted on the landside slope. | | | | | |

Looking at several rodent holes on landside slope. (Fall 2014)

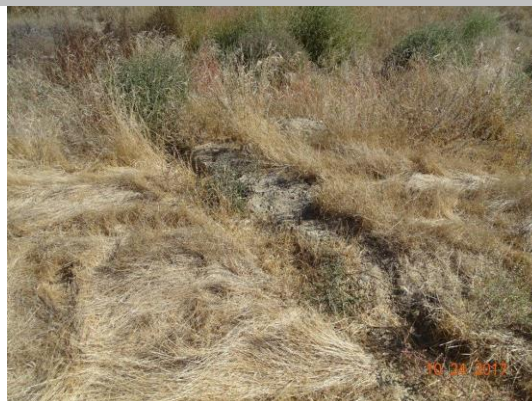
Photo 1 of 1 : FA_2020_NA0010_135_24_20200901_00005.jpg

| Rodent holes are on the landside and crown of levee. Rodent holes have caused some erosion on the landside slope. | | | | | |

Looking east at the landside slope.

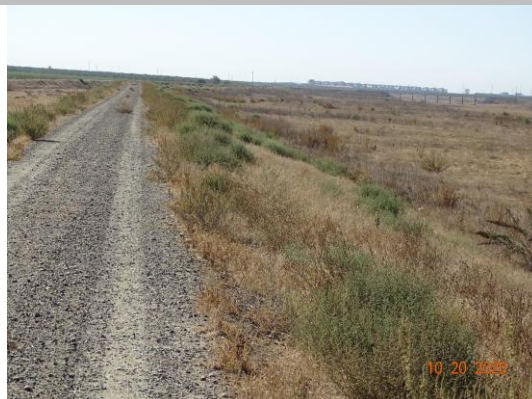
Photo 1 of 1 : FA_2020_NA0010_135_17_20201109_00032.jpg

Vegetation on the waterside slope looking upstream. (Fall 2020)

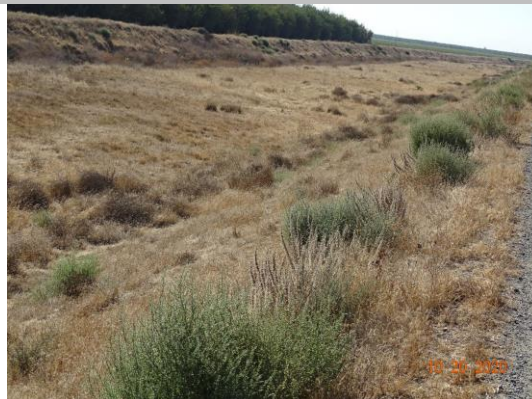
Photo 1 of 1 : FA_2020_NA0010_135_18_20201109_00033.jpg

Vegetation on the landside slope. (Fall 2020)

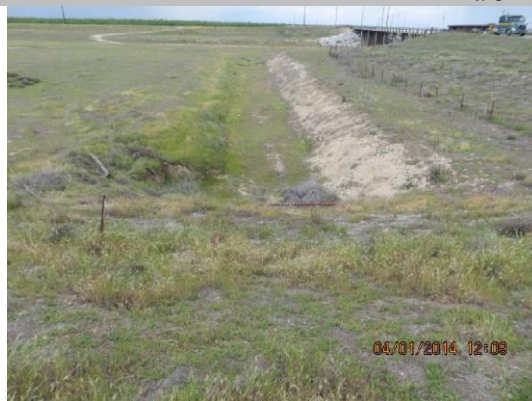
Photo 1 of 3 : UCIP_FA_2020_62093_59723.jpg

| DS_ID:19917 FS_ID:62093 EP_NO: N/A Repair Type: Non-Urgent EVAL Issue: Crossing Status: Found UCIP Comments: 04/01/2014 Dense vegetation limits the inspector's visibility to identify signs of pipe failure (leaks) along the landward slope. Recommend removing vegetation along pipe alignment to conduct proper inspection of structure. (W. Wylie - DWR UCIP) FIELD_STRUCT_DESC: 48-inch by 60-inch reinforced concrete box gravity drainage culvert through the levee, 15 feet below the crown. Concrete headwall on the landside (LS) end. Concrete U-shaped headwall on the waterside (WS) end. [Additional Reference(s): DWR Levee Log, 2002 (HLM 9.89), listed as a 48-inch by 60-inch reinforced concrete box culvert (RCBC). USACE San Joaquin O&M Manual, Unit 601 Part 1 (SJR601.1), 1967, (HLM 9.89), listed as a 5-feet by 4-feet RCBC]. FS Date: 4/1/2014 | | | | | | |

Concrete headwall and channel on WS toe.

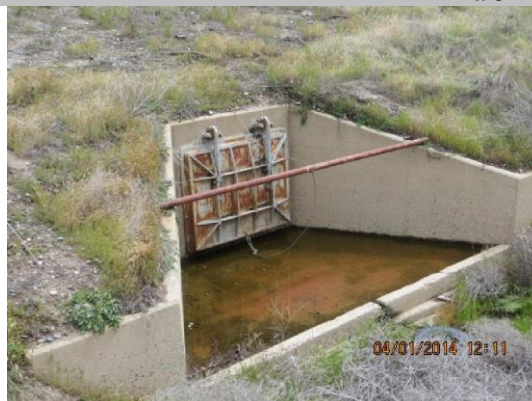
Photo 2 of 3 : UCIP_FA_2020_62093_59724.jpg

Flapgate on Concrete headwall at WS toe.

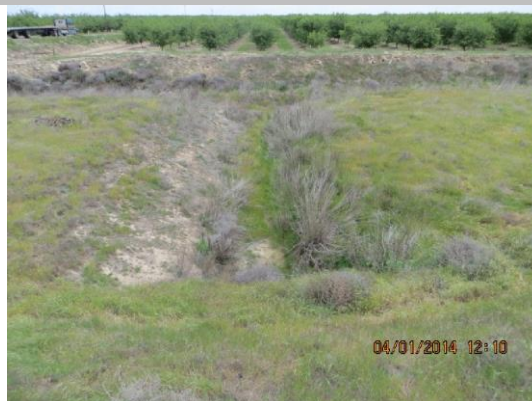
Photo 3 of 3 : UCIP_FA_2020_62093_59722.jpg

Concrete headwall and channel on LS toe.

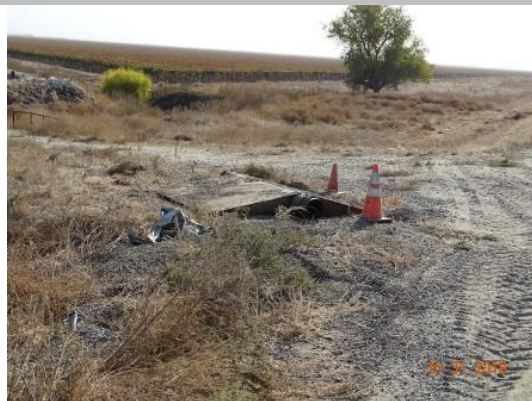
Photo 1 of 2 : FA_2020_NA0010_135_35_20200901_00006.jpg

| Temporary pipe and ramp were moved off the levee crown in Fall 2019 and are currently being stored on the waterside slope. | | | | | |

View of ramp and temporary pipe material left on the waterside slope.
(Fall 2019)

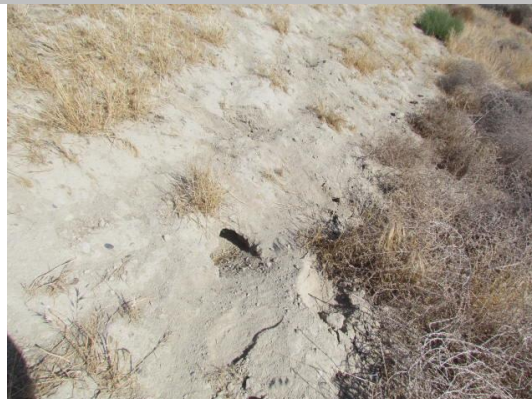
Photo 1 of 1 : FA_2020_NA0010_135_3_20200901_00001.jpg

| Several rodent holes are identified within this reach. | | | | | |

Looking at typical view of rodent holes on landward slope. Fall 2015

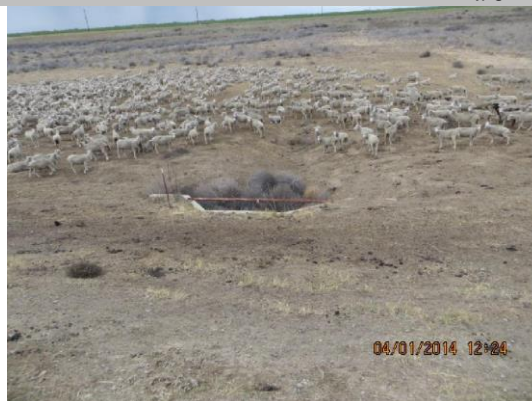
Photo 1 of 3 : UCIP_FA_2020_62094_59727.jpg

| UCIP Comments: 04/01/2014 Some vegetation buildup at inlet--recommend clearing. (W. Wylie - DWR UCIP) | | | | | |

Concrete headwall on WS toe.

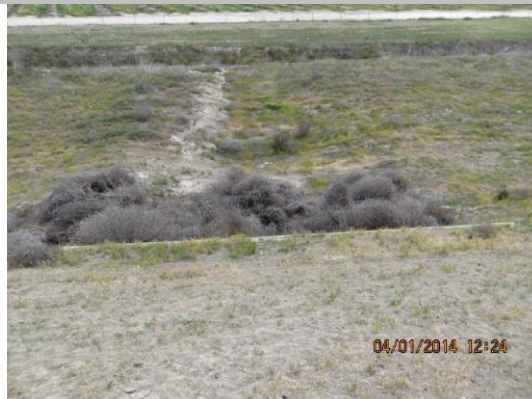
Photo 2 of 3 : UCIP_FA_2020_62094_59726.jpg

Concrete headwall on LS toe.

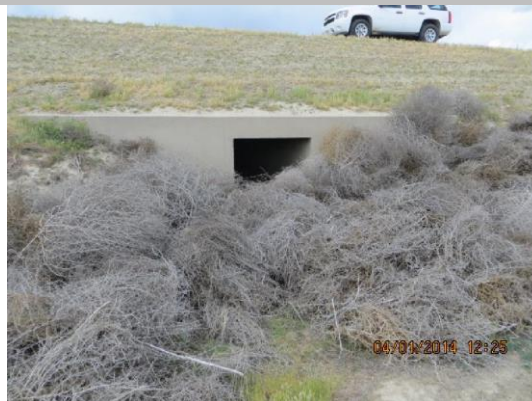
Photo 3 of 3 : UCIP_FA_2020_62094_59725.jpg

Concrete headwall on LS toe. Some vegetation buildup.

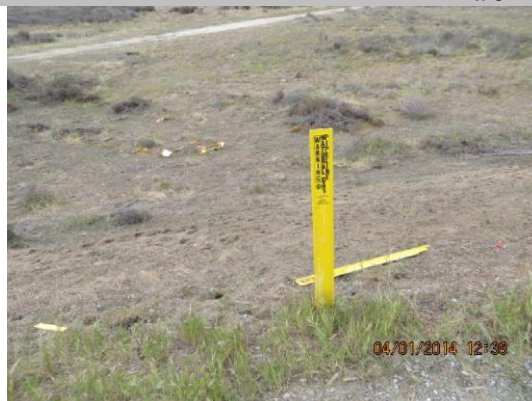
Photo 1 of 3 : UCIP_FA_2020_62095_71490.jpg

Gasline marker on WS slope..

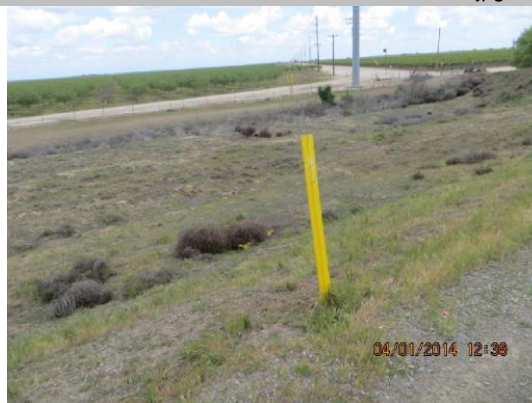
Photo 2 of 3 : UCIP_FA_2020_62095_71489.jpg

Gasline marker on LS shoulder.

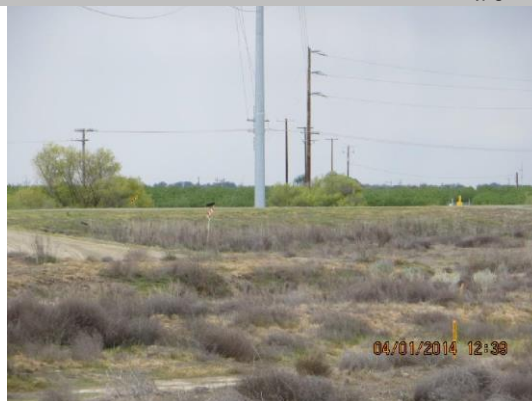
Photo 3 of 3 : UCIP_FA_2020_62095_71488.jpg

Gasline markers visible along right side of photo.

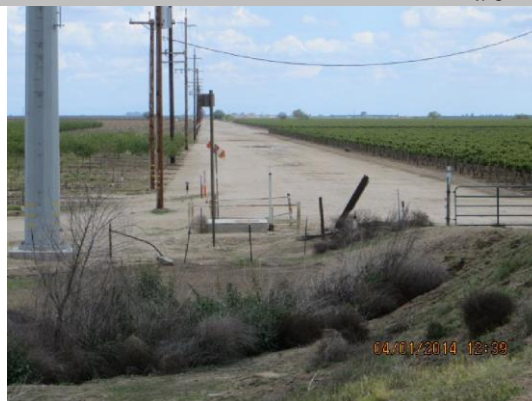
Photo 1 of 3 : UCIP_FA_2020_62096_59742.jpg

DS_ID:19562
 FS_ID:62096
 EP_NO: 18568
 Repair Type: Non-Urgent
 EVAL Issue:
 Crossing Status: Indicator Found
 UCIP Comments: 7/20/2016 Marker visible on LS. WS marker missing.
 (O. Magana - DWR UCIP)4/01/2014 Need to contact owner to confirm and obtain status of crossing. Markers misleading--unable to confirm if markers correspond to this crossing. Need markers at levee.
 (W. Wylie)
 FIELD_STRUCT_DESC: 30-inch coated steel natural gas pipeline through the levee, approximately 60 feet below the crown. Gas line markers are visible on the waterside (WS) and the landside (LS). (30-inch horizontal directional bore (HDD) authorized under Permit No. 18568, 2010 - Gill Ranch Storage, LLC).
 FS Date: 7/20/2016

Gasline marker and concrete sump off LS toe.

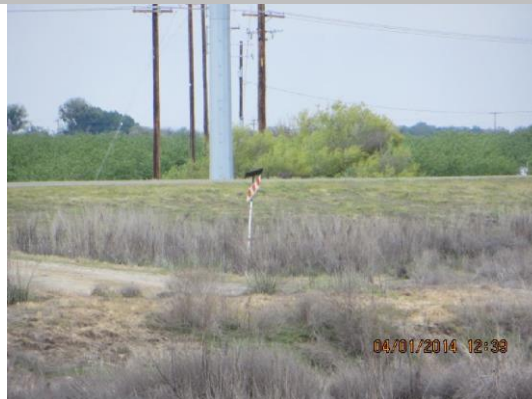
Photo 2 of 3 : UCIP_FA_2020_62096_59741.jpg

Gasline marker visible in channell off WS toe.

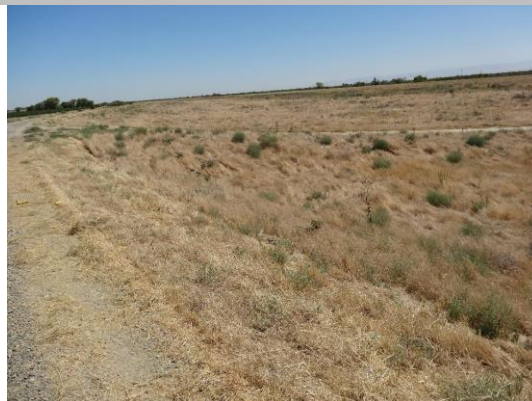
Photo 3 of 3 : UCIP_FA_2020_62096_75506.jpg

View of WS.

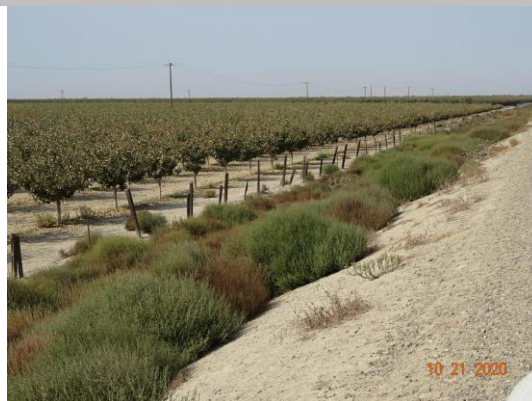
Photo 1 of 1 : FA_2020_NA0010_137_28_20201109_00023.jpg

Looking downstream along the landside slope. (Fall 2020)

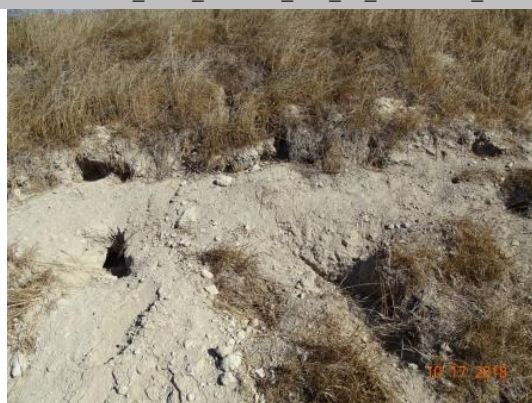
Photo 1 of 1 : FA_2020_NA0010_137_55_20200901_00010.jpg

View of rodent holes from levee toe looking towards centerline. (Fall 2018)

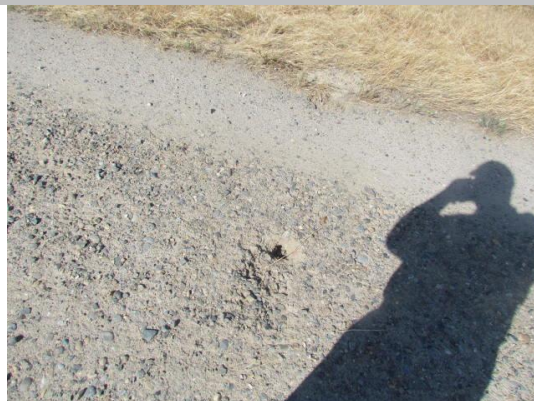
Photo 1 of 1 : FA_2020_NA0010_137_7_20200901_00001.jpg

| There are several rodent holes identified on landside slope and on the levee crown. | | | | | |

Looking at typical view of rodent holes within this section on landward slope.

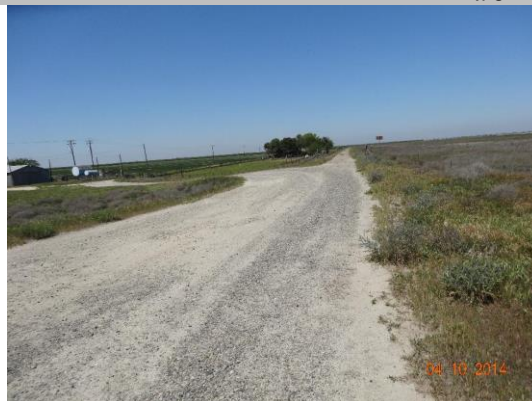
Photo 1 of 3 : UCIP_FA_2020_39503_66660.jpg

| DS_ID:19925 FS_ID:39503 EP_NO: 6603 Repair Type: Non-Urgent EVAL Issue: Crossing Status: Found UCIP Comments: 04/10/2014 Need to contact owner. Appears abandoned--good candidate for video or pressure inspection. This crossings is the same age as the pipe that has failed immediately upstream. (DWR UCIP - O. Magana) FIELD_STRUCT_DESC: 15-inch steel irrigation discharge pipe through the levee, 4.3 feet below the crown. Electrical conduit of an unknown size or material through the levee, 4.3 feet below the crown. Siphon breaker on the landside (LS) shoulder. 36-inch concrete standpipe on the LS berm. Inlet facility on the waterside (WS) bank consisting of a pump, a 42-inch concrete standpipe, and a 20-inch concrete channel with an intake pipe and a cutoff wall. (Plans to install a pump and outlet pipe at two locations on the left bank levee of the Chowchilla Bypass authorized under Permit No. 6603, 1969 - Raymond N. Costales). [Additional Reference(s): DWR Levee Log, 2002]. FS Date: 4/10/2014 | | | | | | |

Overview of levee crown at crossing.

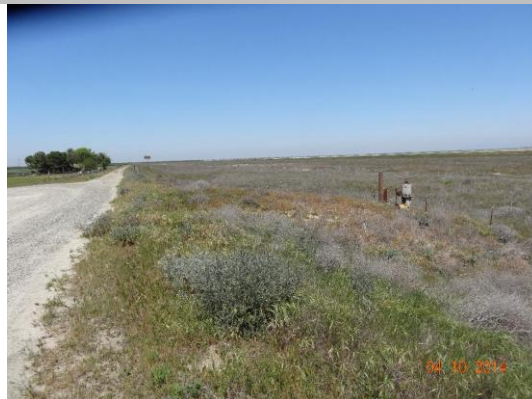
Photo 2 of 3 : UCIP_FA_2020_39503_66657.jpg

View of waterward side.

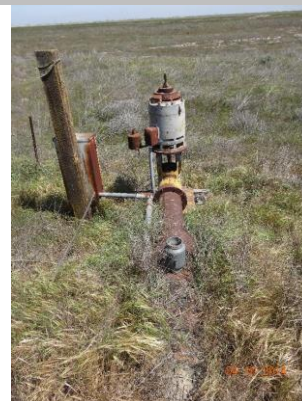
Photo 3 of 3 : UCIP_FA_2020_39503_66658.jpg

Pump system located on waterward slope.

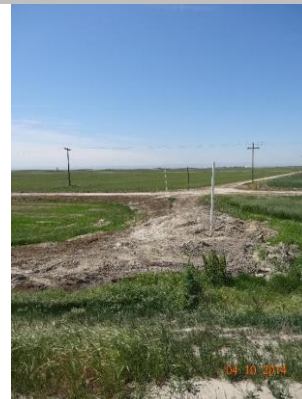
Photo 1 of 3 : UCIP_FA_2020_49968_60558.jpg

DS_ID:19926
FS_ID:49968
EP_NO: 6603
Repair Type: Non-Urgent
EVAL Issue:
Crossing Status: Found
UCIP Comments: 7/20/2016 High burrow activity. Dense vegetation limits the inspector's visibility to identify signs of pipe failure (leaks) along the WS and LS slope. Recommend removing vegetation along pipe alignment to conduct proper inspection of structure and appurtenances. (DWR UCIP - omagana)4/10/2014 Subsidence present along pipe alignment on landward side. Modified crossing--worked done on landward side. Need to contact owner to determine permit authorizing work. Dense vegetation on landward side--tall grass. Pipe wall cut and new pipe sleeved on landward side. (DWR UCIP - omagana)
FIELD_STRUCT_DESC: 15-inch steel irrigation discharge pipe and electrical conduit through the levee, 3.7 feet below the crown. Siphon breaker on the landside (LS) shoulder. 36-inch concrete standpipe on the LS berm. Inlet facility on the riverbank, consisting of a pump, a 42-inch concrete standpipe, and a 20-inch concrete channel with an intake pipe and a cutoff wall. (Plans to install a pump and outlet pipe at two locations on the left bank levee of the Chowchilla Bypass authorized under Permit No. 6603, 1969 - Raymond N. Costales). [Additional Reference(s): DWR Levee Log, 2002].

Overview of LS--site modified.

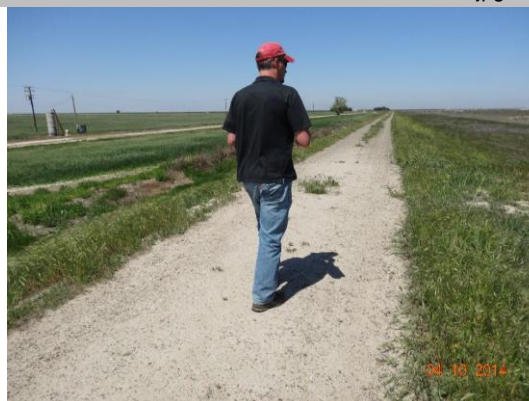
Photo 2 of 3 : UCIP_FA_2020_49968_60559.jpg

View of levee crown at crossing.

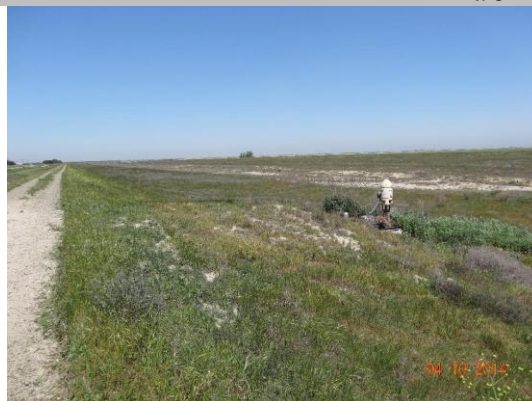
Photo 3 of 3 : UCIP_FA_2020_49968_60560.jpg

View of WS.

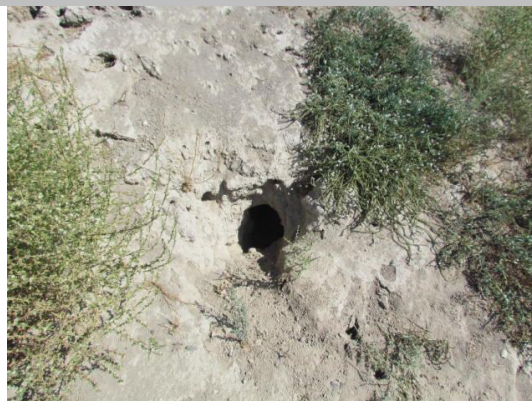
Photo 1 of 1 : FA_2020_NA0010_137_8_20200901_00002.jpg

| There is one large rodent hole and other smaller rodent holes within this area. | | | | | |

Looking at large rodent hole on landward slope.

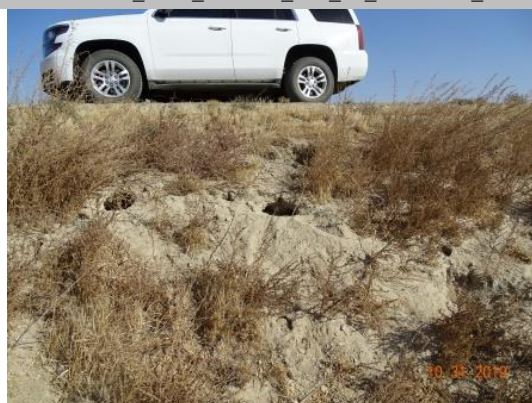
Photo 1 of 1 : FA_2020_NA0010_137_31_20200901_00008.jpg

View of rodent burrows in the landside slope. (Fall 2019)

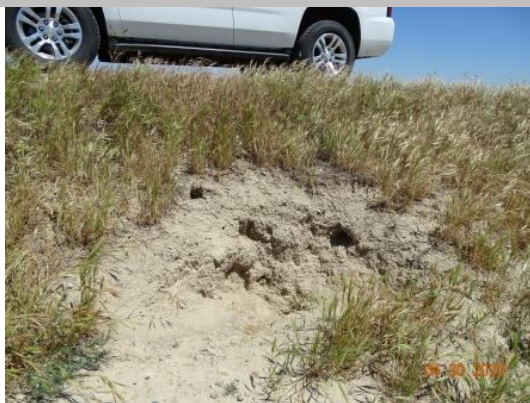
Photo 1 of 1 : FA_2020_NA0010_137_47_20200901_00009.jpg

Large rodent burrow in the landside slope. (Spring 2020)

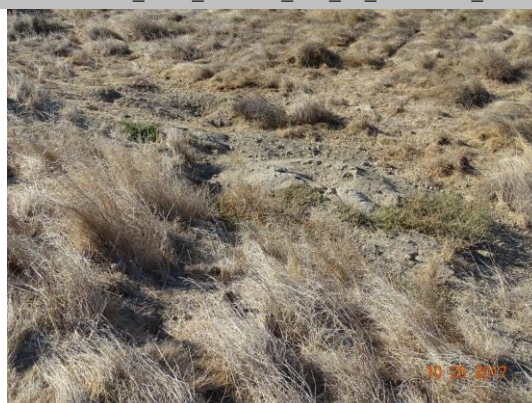
Photo 1 of 1 : FA_2020_NA0010_137_15_20200901_00005.jpg

| There are multiple large rodent holes at the landside toe. | | | | | |

Looking west at the landside slope. (Fall 2017)

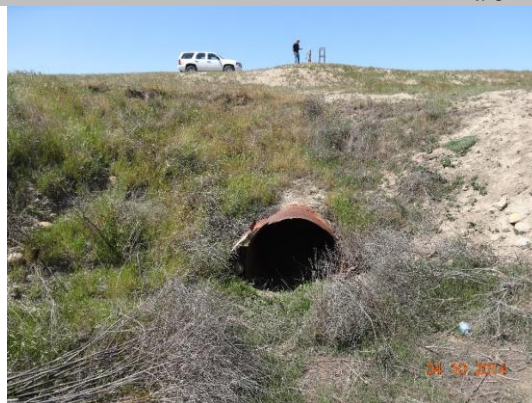
Photo 2 of 3 : UCIP_FA_2020_36843_67205.jpg

Pipe section distorted on waterward side.

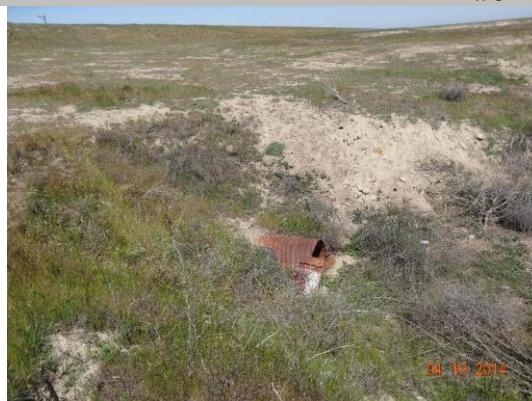
Photo 3 of 3 : UCIP_FA_2020_36843_67200.jpg

CMP section visible on waterward side.

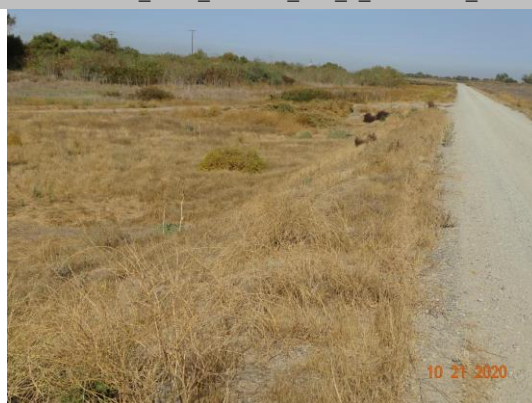
Photo 1 of 1 : FA_2020_NA0010_137_5_20201109_00024.jpg

Looking downstream along the landside slope. (Fall 2020)

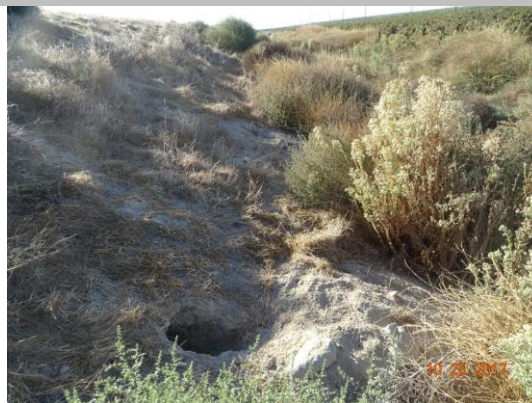
Photo 1 of 1 : FA_2020_NA0010_137_13_20200901_00003.jpg

Looking south at the landside slope.

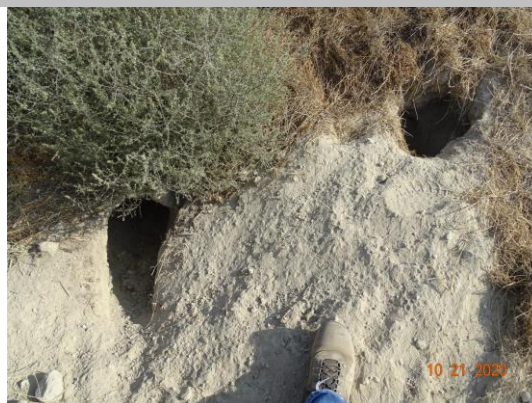
Photo 1 of 1 : FA_2020_NA0010_137_18_20201109_00025.jpg

Large rodent holes in the landside slope. (Fall 2020)

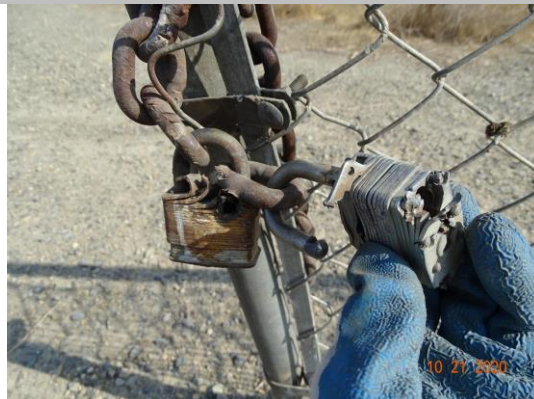
Photo 1 of 1 : FA_2020_NA0010_137_17_20201109_00026.jpg

| Locks on gate have been destroy and can no longer secure gate. | | | | | |

Gunshot damage to locks on gate. (Fall 2020)

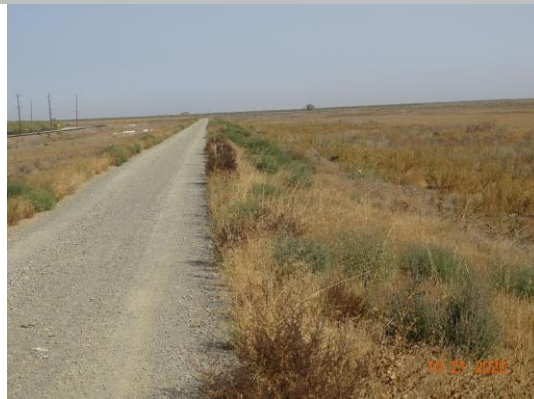
Photo 1 of 1 : FA_2020_NA0010_137_10_20201109_00027.jpg

Looking downstream along the waterside slope. (Fall 2020)

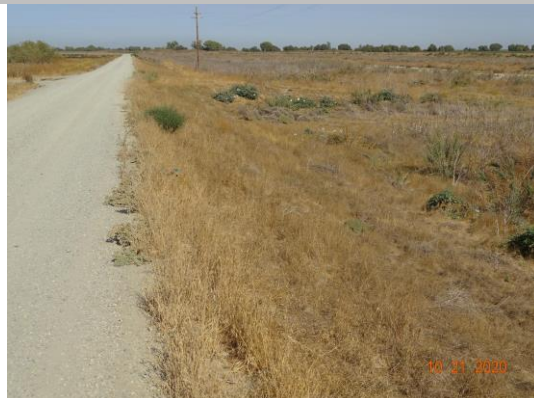
Photo 1 of 1 : FA_2020_NA0010_137_6_20201109_00028.jpg

View of the waterside slope looking downstream. (Fall 2020)

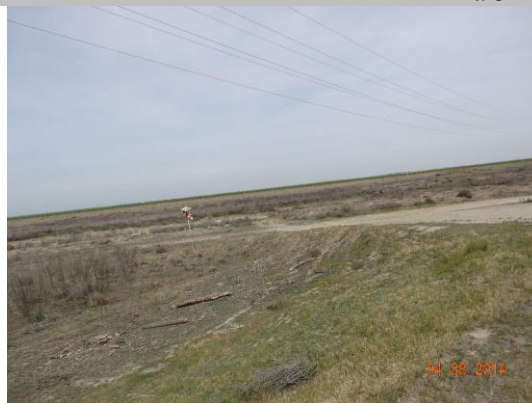
Photo 1 of 3 : UCIP_FA_2020_39505_67226.jpg

| DS_ID:19932 FS_ID:39505 EP_NO: N/A Repair Type: Non-Urgent EVAL Issue: Crossing Status: Indicator Found UCIP Comments: 04/08/2014 Multiple markers visible along waterward and landward sides unable to confirm how many crossings go through levee. Need to contact owner to obtain additional details on crossings. (DWR UCIP - O. Magana) FIELD_STRUCT_DESC: 6-inch natural gas pipeline of an unknown material through the levee. Pipeline extends underneath the channel. [Additional Reference(s): DWR Levee Log, 2002]. FS Date: 4/8/2014 | | | | | |

Markers visible on waterward side.

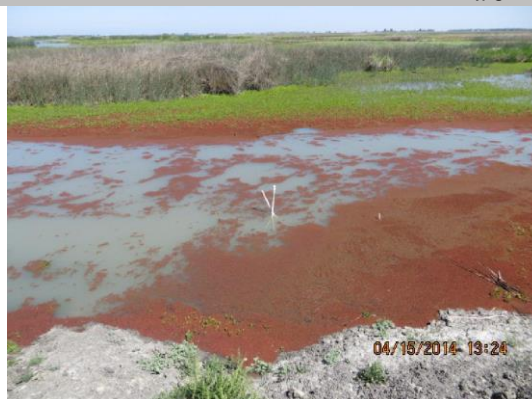
Photo 1 of 3 : UCIP_FA_2020_62171_61060.jpg

| DS_ID:19933 FS_ID:62171 EP_NO: N/A Repair Type: Non-Urgent EVAL Issue: Crossing Status: Found UCIP Comments: 07/19/2016 Gate inside riser appears operable--riser lid damage. Crossing is not visible on LS due to dense vegetation. Recommend clearing dense vegetation along WS and LS slope and repairing riser cover. (O. Magana - DWR UCIP)04/15/2014 No actuator wheel on slide gate at WS shoulder. (W. Wylie - DWR UCIP) FIELD_STRUCT_DESC: 24-inch corrugated metal gravity drainage pipe through the levee, 14.8 feet below the crown. Slide gate in a 36-inch corrugated metal pipe (CMP) riser on the waterside (WS) slope. Concrete U-shaped headwall on each end. [Additional Reference(s): DWR Levee Log, 2002 (HLM 0.10), listed as a 24-inch corrugated metal pipe (CMP). USACE San Joaquin O&M Manual, Unit 601 Part 1 (SJR601.1), 1967, Revised 25 May 2011, (HLM 0.10), listed as a 24-inch CMP]. FS Date: 7/19/2016 | | | | | |

PVC pipes sticking up out of channel likely indicate pipe location on WS toe.

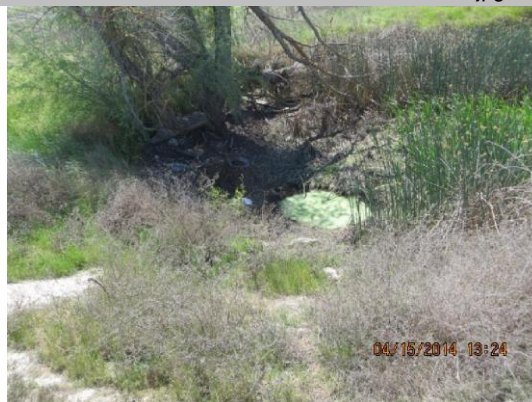
Photo 2 of 3 : UCIP_FA_2020_62171_61061.jpg

Concrete headwall at toe of LS slope.

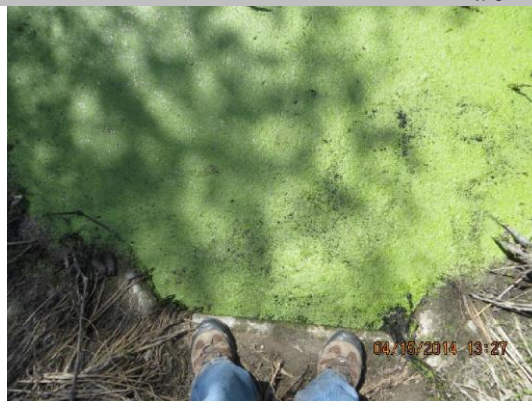
Photo 3 of 3 : UCIP_FA_2020_62171_61059.jpg

Concrete headwall at LS toe.

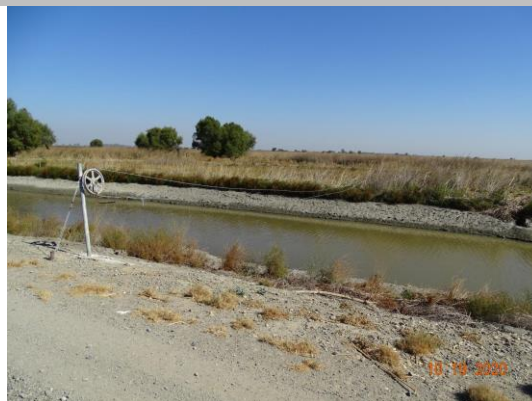
Photo 1 of 1 : FA_2020_NA0010_138_23_20201109_00036.jpg

| A pulley is located on the waterside shoulder without a board permit. | | | | | |

Pulley on the waterside shoulder. (Fall 2020)

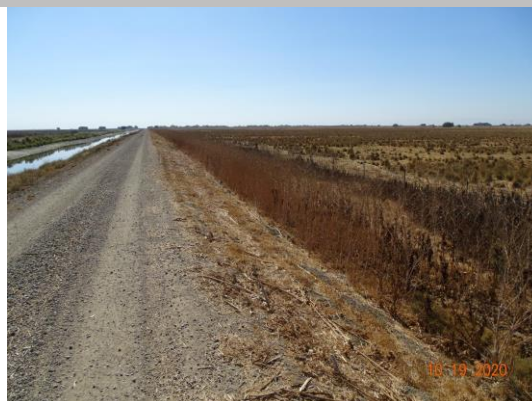
Photo 1 of 1 : FA_2020_NA0010_138_5_20201109_00037.jpg

Looking upstream at vegetation along the landside slope. (Fall 2020)

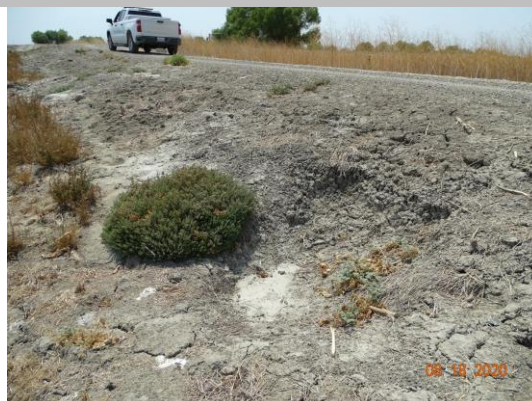
| Site ID: NA0010U22RM5.47 08/18/2020: No changes observed since the previous inspection. 08/28/2019: Two erosion pockets were found at the site, close to levee shoulder, and likely caused by animal activities. | | | | | |

8/18/2020: View of the levee slope looking upstream.

8/18/2020: Close-up view of one the the two erosion pockets.

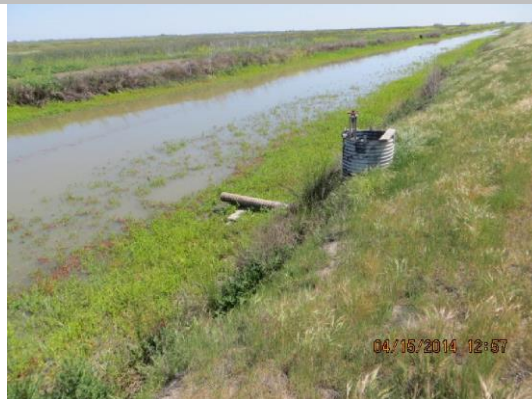
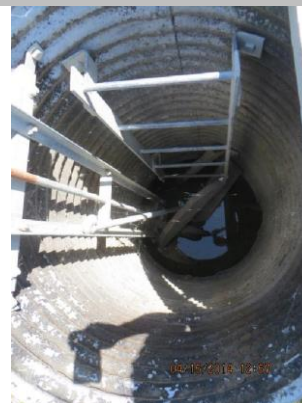
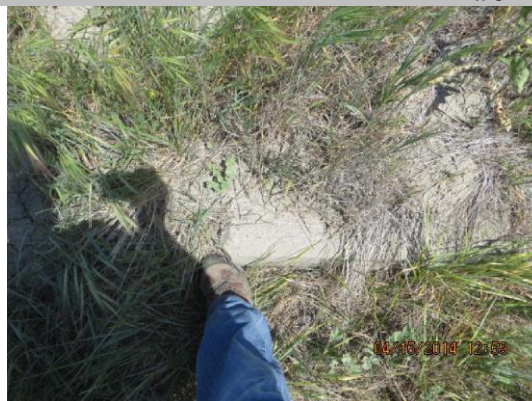
DS_ID:19936
FS_ID:62180
EP_NO: N/A
Repair Type: Non-Urgent
EVAL Issue:
Crossing Status: Found
UCIP Comments: 04/15/2014 Slide gate rusted and does not function. Headwall buried at LS toe. Pipe appears abandoned and if so should be done so properly. (W. Wylie - DWR UCIP)
FIELD_STRUCT_DESC: 8-inch corrugated metal gravity irrigation pipe through the levee, 7 feet below the crown. Slide gate in a 36-inch corrugated metal pipe (CMP) riser on the waterside (WS) slope. Concrete headwall on the landside (LS) end. [Additional Reference(s): DWR Levee Log, 2002 (HLM 1.57), listed as a 8-inch corrugated metal pipe (CMP). USACE San Joaquin O&M Manual, Unit 601 Part 1 (SJR601.1), 1967, Revised 25 May 2011, (HLM 1.57), listed as a 8-inch CMP]
FS Date: 4/15/2014

Pipe and CMP riser with slide gate visible on WS slope.

Inside CMP riser on WS shoulder.

Burried concrete headwall on LS toe.

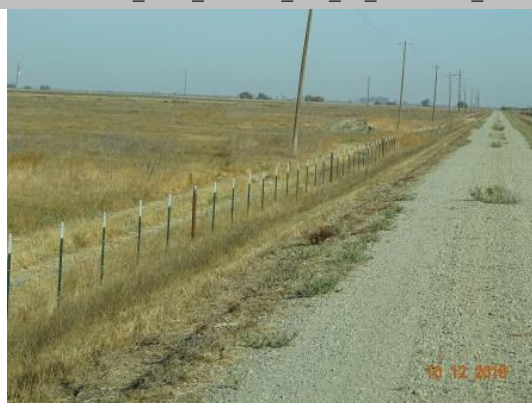
Photo 1 of 1 : FA_2020_NA0010_138_28_20200901_00009.jpg

| A fence is located along the landside toe. | | | | | |

View of fence along landside toe. (Fall 2018)

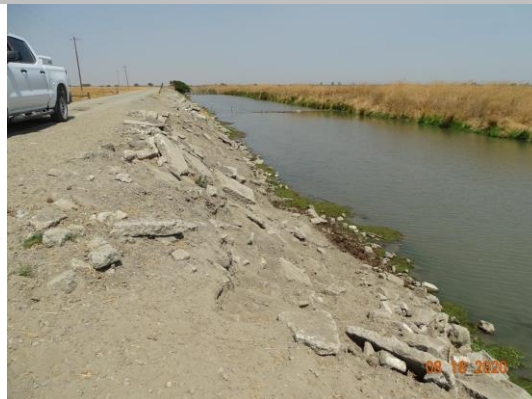
08/18/2020: The site has been covered with loose fill and crushed concrete pieces. The erosion will likely worsen again during the next high water.

09/12/2019: The erosion has cut into the levee prism and damaged almost half of the levee. The livestock traffic has likely caused the erosion.

8/18/2020: View of the erosion looking downstream with fill and crushed concrete.

8/18/2020: View of the erosion looking upstream.

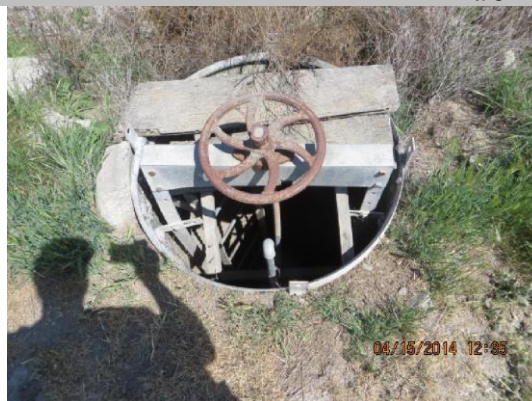
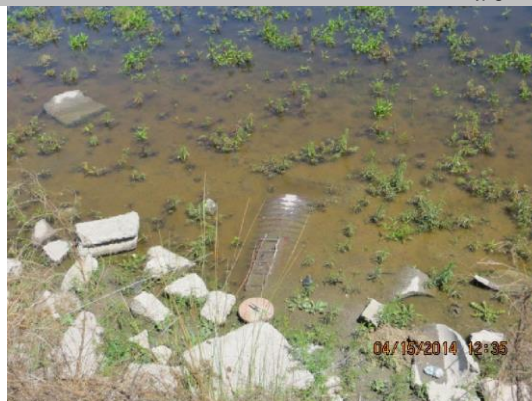
| DS_ID:19937 FS_ID:62181 EP_NO: N/A Repair Type: Non-Urgent EVAL Issue: Crossing Status: Found UCIP Comments: 04/15/2014 Slide gate does not function and should be repaired. Headwall at LS toe not found. (W. Wylie - DWR UCIP) FIELD_STRUCT_DESC: 24-inch corrugated metal irrigation siphon pipe through the levee, 7.5 feet below the crown. Slide gate in a 36-inch corrugated metal pipe (CMP) riser on the waterside (WS) slope. Concrete U-shaped headwall on the landside (LS) end. [Additional Reference(s): DWR Levee Log, 2002 (HLM 2.72), listed as a 24-inch corrugated metal pipe (CMP). USACE San Joaquin O&M Manual, Unit 601 Part 1 (SJR601.1), 1967, Revised 25 May 2011, (HLM 2.72), listed as a 24-inch CMP]. FS Date: 4/15/2014 | | | | | | |

Slidegate in CMP riser on WS shoulder. (Note: actuator does not work).

Inside CMP riser on WS shoulder.

Pipe visible on WS toe.

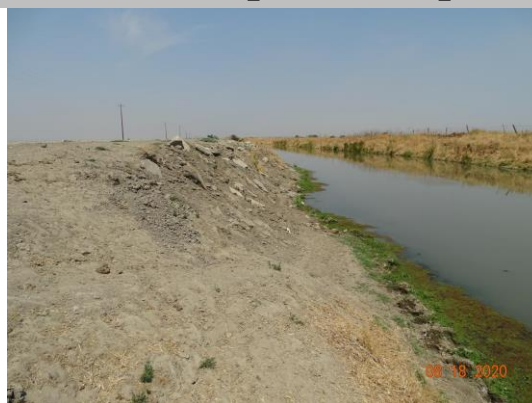
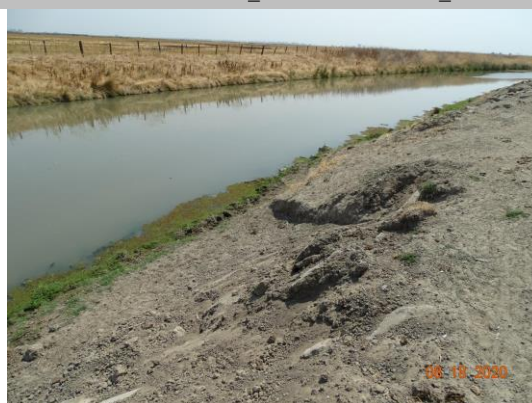
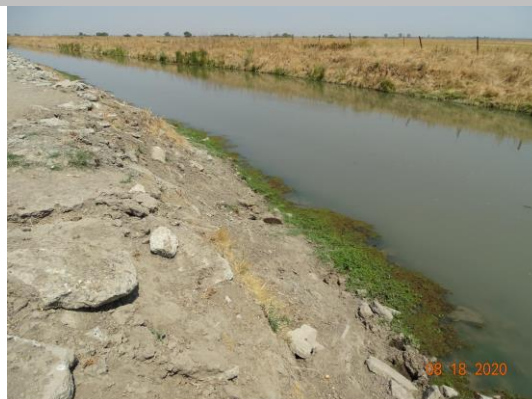
08/18/2020: No changes observed since the previous inspection. In some areas, the levee shoulder width is up to 8 ft. There is some crushed concrete on the levee slope.
09/12/2019: The erosion has damaged entire levee slope. The livestock traffic likely has caused the erosion.

8/18/2020: View of the erosion looking downstream.

8/18/2020: Close-up view of the erosion.

8/18/2020: View of the erosion looking downstream with crushed concrete visible on the levee slope.

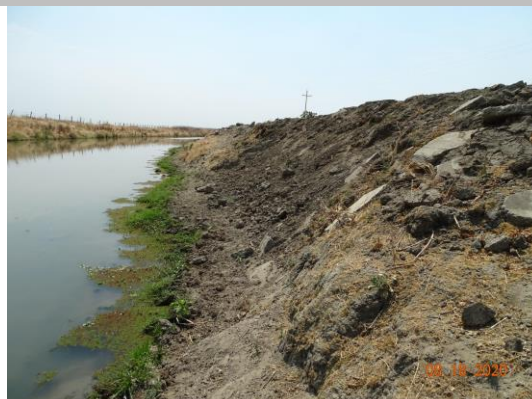
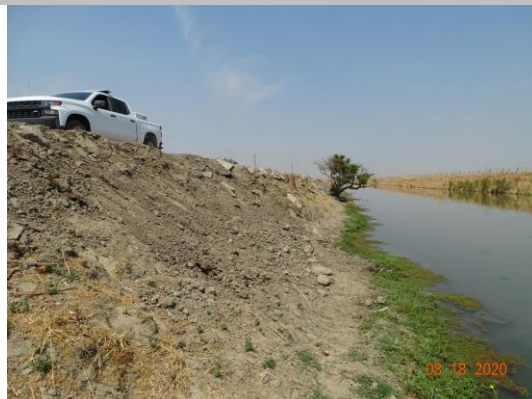
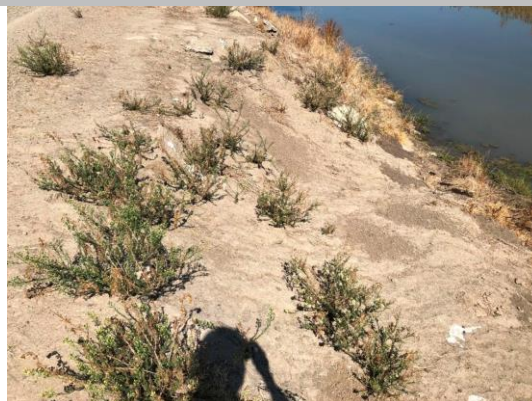
08/18/2020: No vegetation visible in the area of the erosion. Noticed some crushed concrete pieces on the levee slope and a small amount of loose fill.

09/12/2019: The erosion has damaged entire levee slope. The livestock traffic likely has caused the erosion.

8/18/2020: View of the erosion looking upstream.

8/18/2020: View of the erosion looking downstream.

9/12/2020: Close-up view of the erosion.

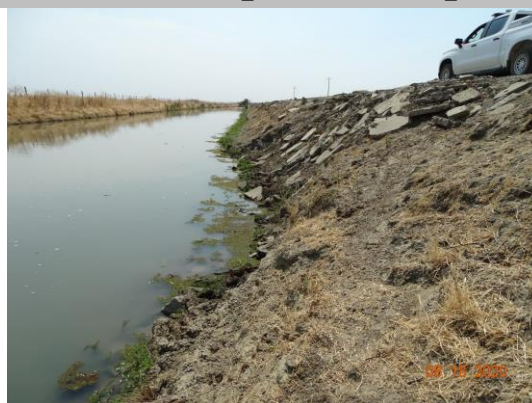
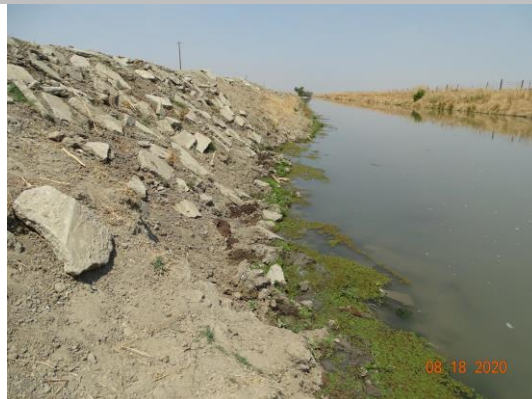
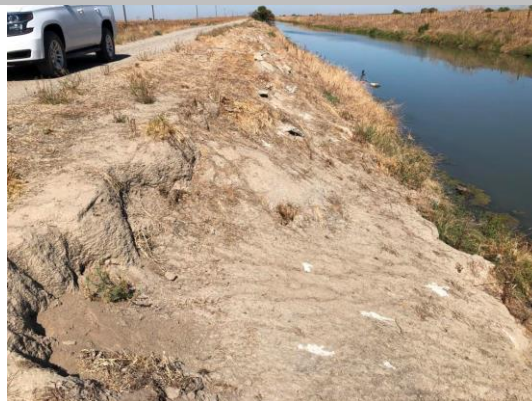
08/18/2020: The erosion has been covered with loose fill and crushed concrete pieces. A nearly vertical slope remains at the levee toe in some sections. The site will likely worsen again during the next high water.

09/12/2019: The erosion has damaged entire levee slope. The livestock activity likely has caused the erosion.

8/18/2020: View of the erosion and crushed concrete on the slope.

8/18/2020: Close-up view of the erosion looking downstream.

9/12/2019: Looking down at the erosion pocket.

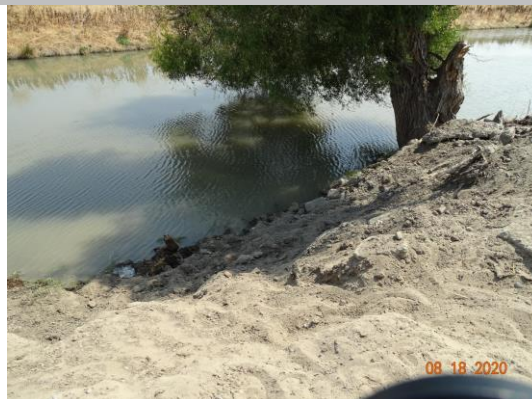
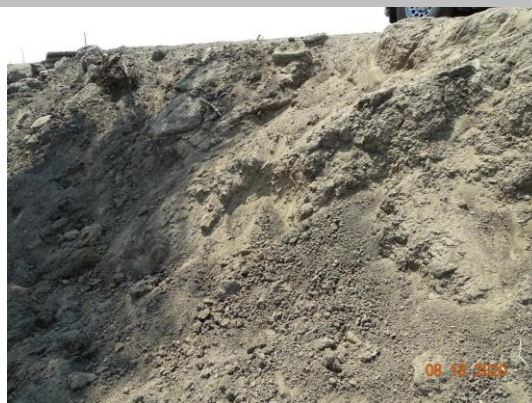
08/18/2020: The erosion has slightly worsened and cut into the levee prism. The site is immediately downstream of a tree on the levee toe.
09/12/2019: The erosion has damaged the entire levee slope. Livestock activity likely has caused the erosion.

8/18/2020: View of the erosion looking down the levee slope.

8/18/2020: View of the erosion looking upstream.

8/18/2020: Close-up view of the erosion.

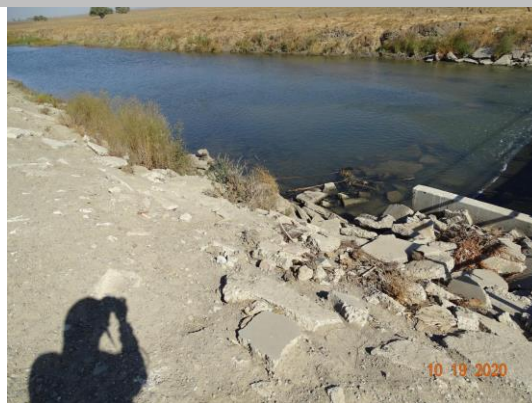
Photo 1 of 1 : FA_2020_NA0010_138_14_20201109_00038.jpg

Waterside slope has been stabilized with broken concrete. (Fall 2020)

| S1 : Repair slope instability. | | | | | |

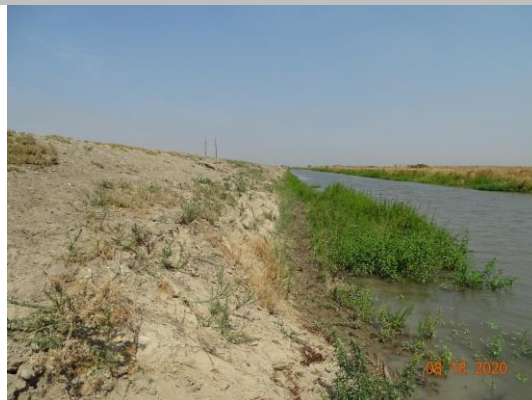
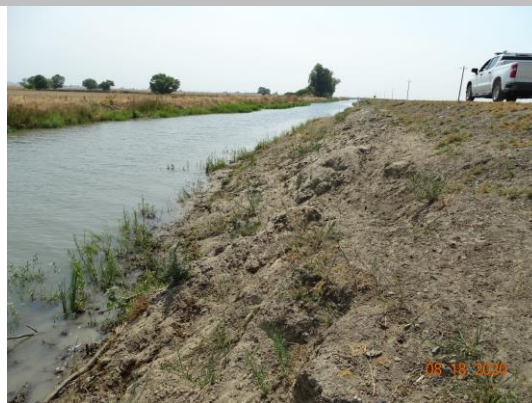
| 08/18/2020: No changes observed since the previous inspection. | | | | | |
| 09/12/2019: Erosion has developed into the lower levee slope. Loose material was observed at the site. | | | | | |

818/2020: Close-up view of the erosion looking downstream.

818/2020: Close-up view of the erosion looking upstream.

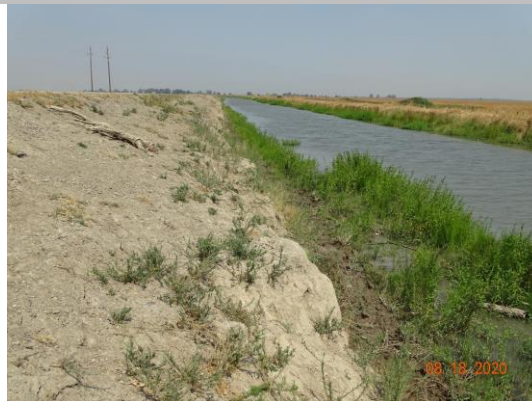
Photo 3 of 3 : SJR2019_NA0010U22RM2.25_06.JPG

818/2020: Another close-up view of the erosion looking downstream.

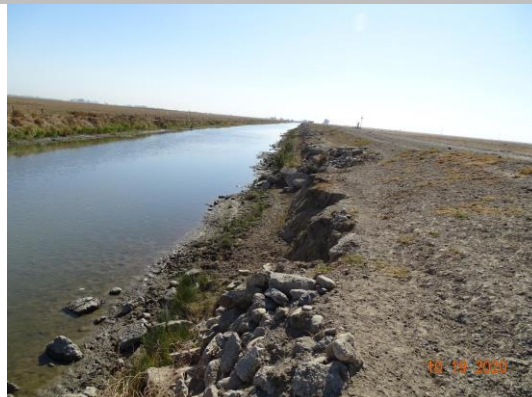
Photo 1 of 1 : FA_2020_NA0010_138_37_20201109_00039.jpg

| Erosion is cutting into the waterside slope. Some sections have been stabilized with cobble stone and broken concrete. | | | | | |

View of waterside slope damage looking upstream. (Fall 2020)

| E2 : Schedule repair of erosion site prior to the next inspection. | | | | | |
