Flood Control Project Maintenance Levee Inspections

Fall 2020 Levee Maintenance Deficiency Summary Report

San Joaquin River Basin

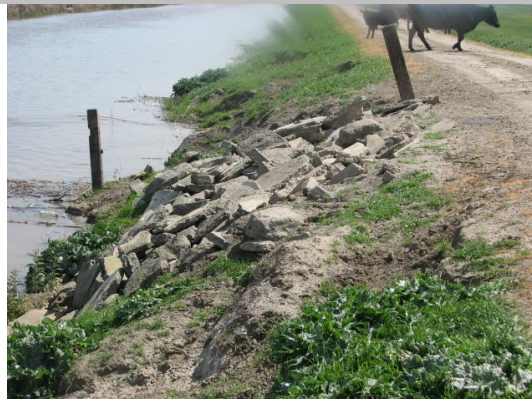
Photo 1 of 1 : FA_2020_NA0010_138_8_20200901_00002.jpg

| Levee damage caused by animal traffic. Several sites repaired with broken concrete. | | | | | |

Looking downstream at repaired site with concrete rubble on waterward slope and shoulder. (Spring 2018)

| A2 : Repair the levee slope damaged by livestock and prevent large animal access. | | | | | |

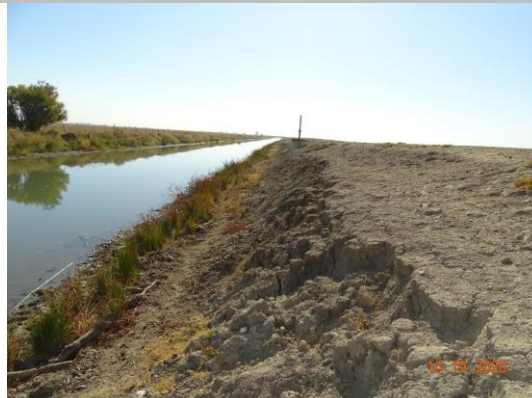
Photo 1 of 1 : FA_2020_NA0010_138_6_20201109_00040.jpg

| Slope damage is caused by livestock on waterside toe. | | | | | |

Looking southeast at livestock erosion on waterward toe. (Fall 2020)

| A2 : Repair the levee slope damaged by livestock and prevent large animal access. | | | | | |

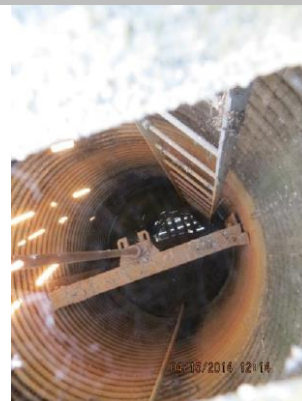
Photo 2 of 3 : UCIP_FA_2020_62182_61021.jpg

Inside riser on WS shoulder.

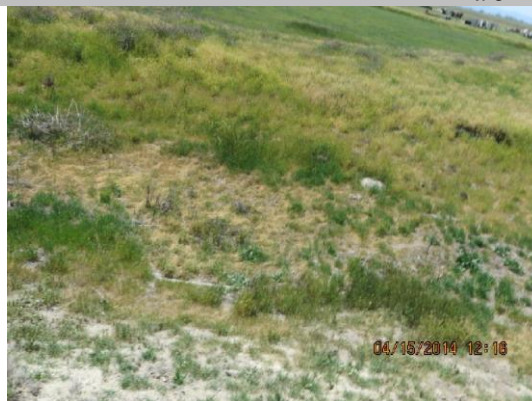
Photo 3 of 3 : UCIP_FA_2020_62182_61020.jpg

| DS_ID:19938 FS_ID:62182 EP_NO: N/A Repair Type: Non-Urgent EVAL Issue: Crossing Status: Found UCIP Comments: 04/15/2014 Need to contact owner. Pipe silted in on LS toe. Appears abandoned and if so should be done so properly. (W. Wylie - DWR UCIP) FIELD_STRUCT_DESC: 48-inch corrugated metal irrigation siphon pipe through the levee, 10 feet below the crown. Slide gate in a 60-inch corrugated metal pipe (CMP) riser on the waterside (WS) slope. Concrete headwall on the landside (LS) end. WS end capped with a 0.25-inch steel plate. [Additional Reference(s): DWR Levee Log, 2002 (HLM 5.48), listed as a 48-inch corrugated metal pipe (CMP). USACE San Joaquin O&M Manual, Unit 601 Part 1 (SJR601.1), 1967, Revised 25 May 2011, (HLM 5.48), listed as a 48-inch CMP] FS Date: 4/15/2014 | | | | | |

Burried headwall on LS toe.

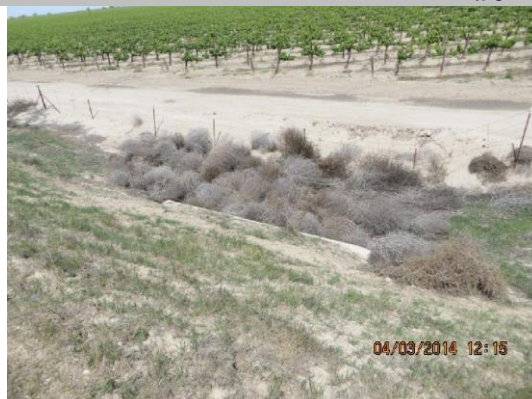
Photo 3 of 3 : UCIP_FA_2020_62191_59861.jpg

| DS_ID:19945 FS_ID:62191 EP_NO: N/A Repair Type: Non-Urgent EVAL Issue: Crossing Status: Found UCIP Comments: 04/03/2014 Excessive vegetation at inlet-recommend clearing. (W. Wylie - DWR UCIP) FIELD_STRUCT_DESC: 30-inch by 30-inch square reinforced concrete box gravity drainage culvert through the levee, 13 feet below the crown. Flap gate on the waterside (WS) end. Concrete headwall on the landside (LS) end. Concrete U-shaped headwall on the WS end. (Plans to construct a new discharge structure and to rehabilitate one existing diversion structure to return intercepted seepage to the San Joaquin River authorized under Permit No. 13085, 1981 - Diener, Dry River Farms). [Additional Reference(s): DWR Levee Log, 2002 (HLM 0.21), listed as a 30-inch square reinforced concrete box culvert (RCBC). USACE San Joaquin O&M Manual, Unit 601 Part 1 (SJR601.1), 1967, Revised 25 May 2011, (HLM 0.21), listed as a 2.5-foot by 2.5-foot RCBC] FS Date: 4/3/2014 | | | | | | |

Concrete headwall at LS toe. Excess vegetation buildup at inlet.

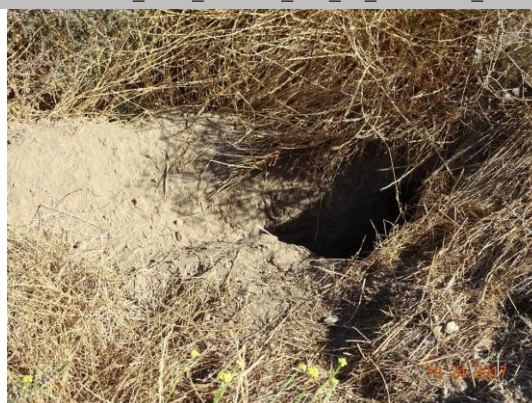
Photo 1 of 1 : FA_2020_NA0010_139_26_20200901_00005.jpg

| Need to repair the large rodent hole on the landside slope. | | | | | |

Looking at the landside slope.

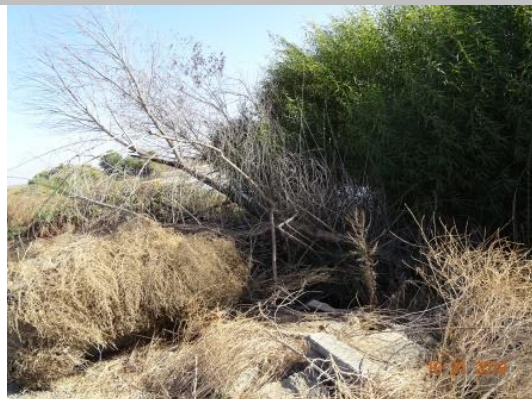
Photo 1 of 1 : FA_2020_NA0010_139_1_20200901_00001.jpg

| There is a downed tree on the waterside slope. | | | | | |

View of fallen tree on the waterside slope. (Fall 2019)

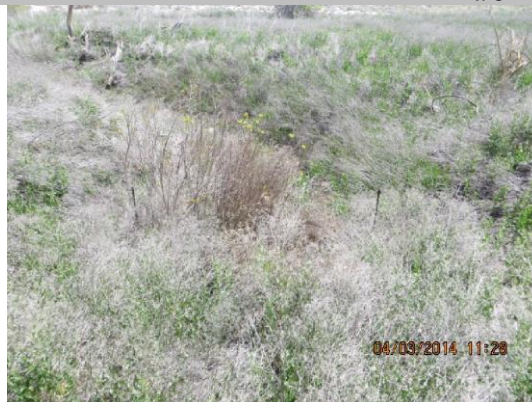
Photo 2 of 3 : UCIP_FA_2020_62197_59847.jpg

| DS_ID:19953 FS_ID:62197 EP_NO: N/A Repair Type: Non-Urgent EVAL Issue: Crossing Status: Found UCIP Comments: 04/03/2014 Heavy vegetation at inlet and outlet-- recommend clearing. (W. Wylie - DWR UCIP) FIELD_STRUCT_DESC: 30-inch by 30-inch square reinforced concrete box gravity irrigation culvert through the levee, 10.7 feet below the crown. 4.5-foot by 7-foot concrete riser with slide gate on the waterside (WS) slope. Concrete U-shaped headwall on each end. 15-foot-long cobble revetted inlet channel. [Additional Reference(s): DWR Levee Log, 2002 (HLM 4.87), listed as a 30-inch square reinforced concrete box culvert (RCBC)]. FS Date: 4/3/2014 | | | | | |

Heavy vegetation in outlet/channel on WS toe.

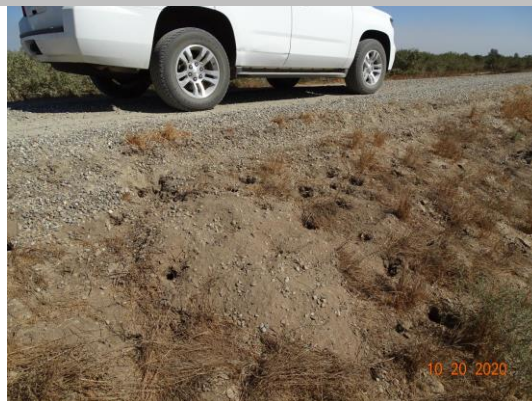
Photo 1 of 1 : FA_2020_NA0010_139_24_20201109_00037.jpg

Several rodent holes noted at this location. (Fall 2020)

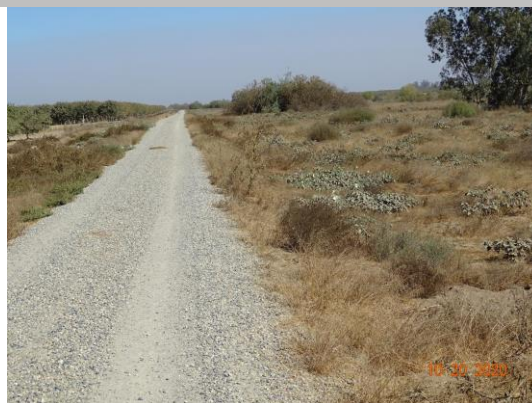
Photo 1 of 1 : FA_2020_NA0010_139_28_20201109_00039.jpg

View of vegetation along the waterside slope. (Fall 2020)

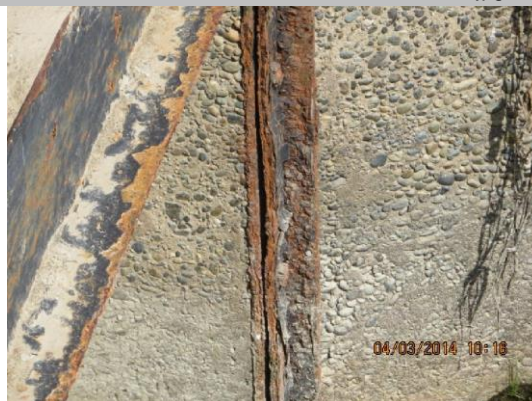
Photo 3 of 3 : UCIP_FA_2020_62205_59808.jpg

DS_ID:19943
FS_ID:62205
EP_NO: N/A
Repair Type: Non-Urgent
EVAL Issue:
Crossing Status: Found
UCIP Comments: 11/01/2018 Limited access to both LS and WS; assumed slide gates are still non-functional; Crossing has been downgraded from Urgent to Non-Urgent due to re-classification of damage slide gates. (O. Magana - DWR UCIP)07/20/2016 No change--same as previous inspection. (O. Magana - DWR UCIP)04/03/2014 Slide gate not functional. Slide gate channels heavily corroded (exfoliated) and likely impact functionality/structural integrity of gate. (W. Wylie - DWR UCIP)
FIELD_STRUCT_DESC: [Gravelly Ford Canal Irrigation Structure] 1 of 2: 48-inch by 63-inch reinforced concrete box gravity irrigation culvert through the levee, 10 feet below the crown. Concrete U-shaped headwall on each end. Gear pedestal slide gate with wall bracket on the waterside (WS) headwall. 10-foot-long cobble revetted outlet channel. Guardrail on each shoulder. Slide gates on the WS. [Additional Reference(s): DWR Levee Log, 2002 (HLM 9.76), listed as a two 4.0-foot by 5.25-foot reinforced concrete box culvert (RCBC). USACE San Joaquin O&M Manual, Unit 601 Part 1 (SJR601.1), 1967, Revised 25 May 2011, (HLM 9.76), listed as a two 5.25-foot by 4-foot barrel RCBC]

Heavy corrosion in slide gate tracks on WS toe.

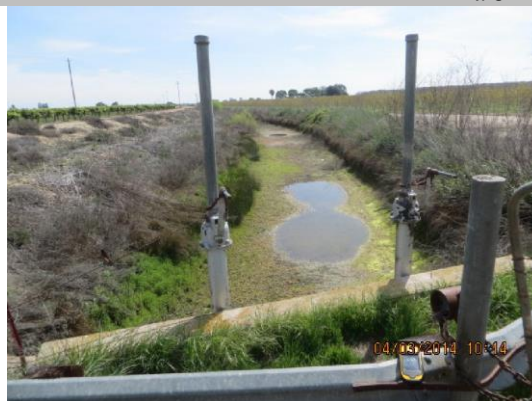
Photo 1 of 3 : UCIP_FA_2020_62206_59802.jpg

Slide gate actuators on Concrete headwall at WS shoulder.

Slide gate tracks show heavy corrosion impacting actuation of slide gate.

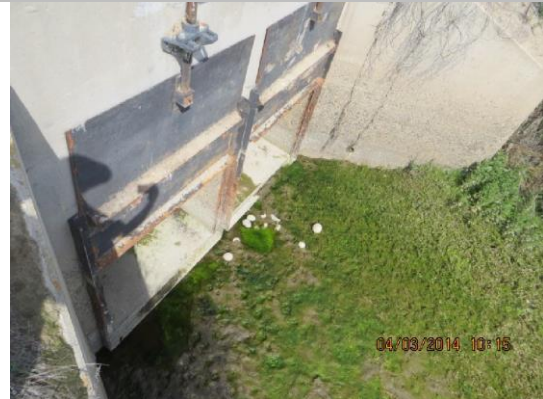
Photo 2 of 3 : UCIP_FA_2020_62206_59801.jpg

DS_ID:19980
FS_ID:62206
EP_NO: N/A
Repair Type: Non-Urgent
EVAL Issue:
Crossing Status: Found
UCIP Comments: 11/01/2018 Limited access to both LS and WS; assumed slide gates are still non-functional; Crossing has been downgraded from Urgent to Non-Urgent due to re-classification of damage slide gates. (O. Magana - DWR UCIP)07/20/2016 No change--same as previous inspection. (O. Magana - DWR UCIP)04/03/2014 Slide gate not functional. Slide gate channels heavily corroded (exfoliated) and likely impact functionality/structural integrity of gate. (W. Wylie - DWR UCIP)
FIELD_STRUCT_DESC: [Gravelly Ford Canal Irrigation Structure] 2 of 2: 48-inch by 63-inch reinforced concrete box gravity irrigation culvert through the levee, 10 feet below the crown. Concrete U-shaped headwall on each end. Gear pedestal slide gate with wall bracket on the waterside (WS) headwall. 10-foot-long cobble revetted outlet channel. Guardrail on each shoulder. [Additional Reference(s): DWR Levee Log, 2002 (HLM 9.76), listed as a two 4.0-foot by 5.25-foot reinforced concrete box culvert (RCBC). USACE San Joaquin O&M Manual, Unit 601 Part 1 (SJR601.1), 1967, Revised 25 May 2011, (HLM 9.76), listed as a two 5.25-foot by 4-foot barrel RCBC].

Slide gates on WS toe.

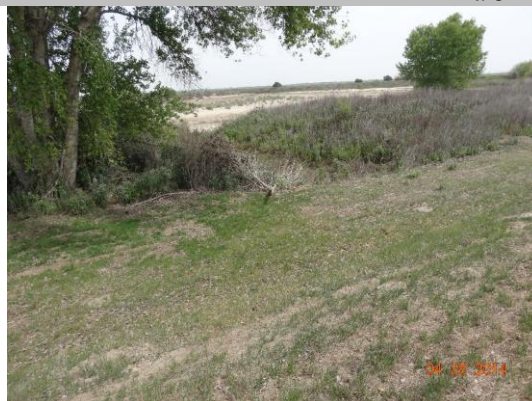
Photo 1 of 3 : UCIP_FA_2020_62209_60059.jpg

| DS_ID:19955 FS_ID:62209 EP_NO: N/A Repair Type: Non-Urgent EVAL Issue: Crossing Status: Found UCIP Comments: 04/08/2014 No access available to confirm condition of landward side headwall. Recommend clearing debris along fence. Surface erosion near concrete headwall on landward side was present. (O. Magana - DWR UCIP) FIELD_STRUCT_DESC: 30-inch by 30-inch square reinforced concrete box gravity drainage culvert through the levee, 13.5 feet below the crown. Flap gate on the waterside (WS) end. Concrete headwall on each end. [Additional Reference(s): DWR Levee Log, 2002 (HLM 0.49), listed as a 30-inch square concrete culvert]. FS Date: 4/8/2014 | | | | | | |

View of waterward side.

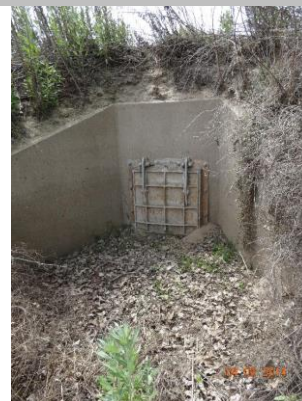
Photo 2 of 3 : UCIP_FA_2020_62209_60057.jpg

Square gate visible on waterward side.

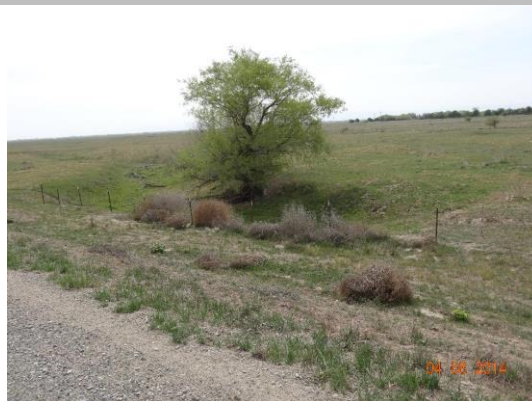
Photo 3 of 3 : UCIP_FA_2020_62209_60058.jpg

View of landward side.

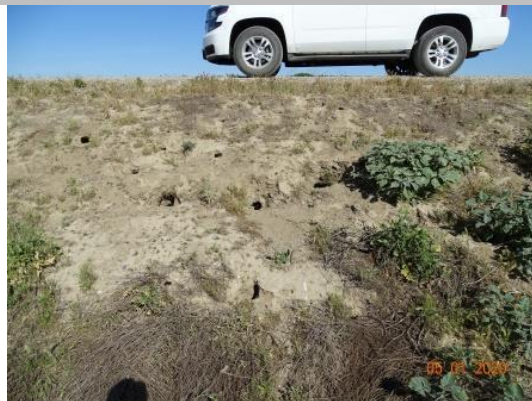
Photo 1 of 1 : FA_2020_NA0010_140_6_20200901_00001.jpg

| There are several rodent holes identified within this section. | | | | | |

Rodent burrows in the landside slope. (Spring 2020)

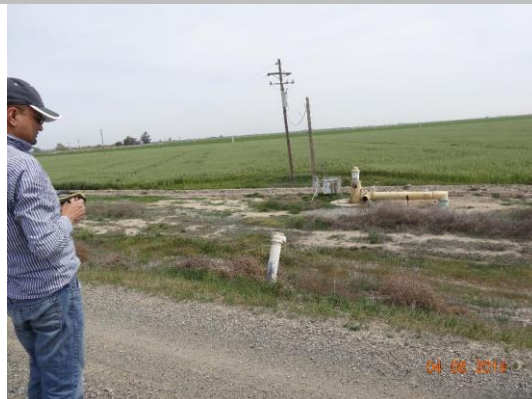
Photo 1 of 2 : UCIP_FA_2020_62210_60065.jpg

| DS_ID:19961 FS_ID:62210 EP_NO: 13735 Repair Type: Non-Urgent EVAL Issue: Crossing Status: Found UCIP Comments: 04/08/2014 Unable to determine status of crossing. Need to contact owner to determine status of crossing. (O. Magana - DWR UCIP) FIELD_STRUCT_DESC: 24-inch coated steel drainage discharge pipe through the levee, 2 feet below the crown. Crown roadway has been padded 1 foot. Steel cutoff wall around the pipe at the centerline of the levee. Pump on the landside (LS). Siphon breaker on the apex of the pipe on the LS shoulder. Galvanized siphon vent pipe on the LS shoulder. (Plans to install two 24-inch steel discharge pipelines through the levee to dispose of seepage water collected in farm sumps Nos. 8 and 12 authorized under Permit No. 13735, 1983 - Rio Seco Farm). [Additional Reference(s): DWR Levee Log, 2002 (HLM 1.07), listed as a 24-inch steel pipe]. FS Date: 4/8/2014 | | | | | |

View of landward side.

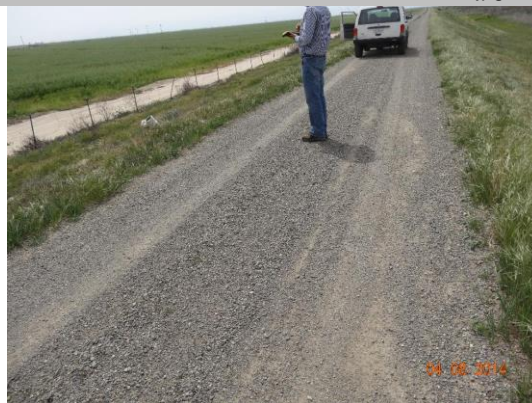
Photo 1 of 3 : UCIP_FA_2020_62212_60075.jpg

| DS_ID:19963 FS_ID:62212 EP_NO: 13735 Repair Type: Non-Urgent EVAL Issue: Crossing Status: Found UCIP Comments: 04/08/2014 Unable to confirm status of crossing. (O. Magana - DWR UCIP) FIELD_STRUCT_DESC: 24-inch coated steel drainage discharge pipe through the levee, 2 feet below the crown. Crown roadway has been padded 1 foot. Steel cutoff wall around the pipe at the centerline of the levee. Pump on the landside (LS). Siphon breaker on the apex of the pipe on the LS shoulder. Galvanized siphon vent pipe on the LS shoulder. (Plans to install two 24-inch steel discharge pipelines through the levee to dispose of seepage water collected in farm sumps Nos. 8 and 12 authorized under Permit No. 13735, 1983 - Rio Seco Farm). [Additional Reference(s): DWR Levee Log, 2002 (HLM 2.68) listed as a 24-inch steel pipe]. FS Date: 4/8/2014 | | | | | |

Overview of levee crown at crossing.

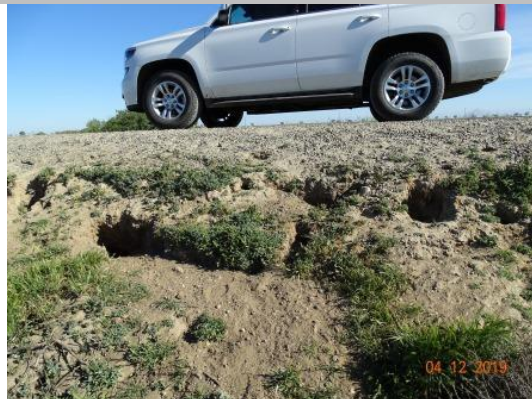
Photo 1 of 1 : FA_2020_NA0010_140_51_20200901_00009.jpg

View of rodent holes in landside slope. (Spring 2019)

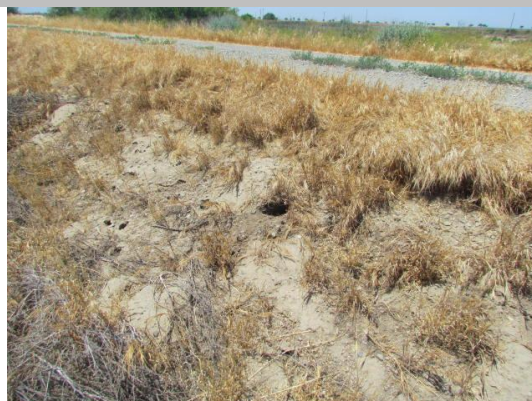
Photo 1 of 1 : FA_2020_NA0010_140_7_20200901_00002.jpg

| There are several rodent holes on the landside slope. | | | | | |

Looking east at one of several rodent holes on landward slope.

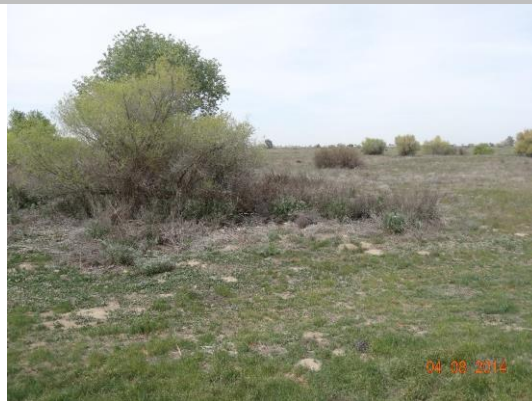
Photo 1 of 3 : UCIP_FA_2020_62213_67237.jpg

| DS_ID:19964 FS_ID:62213 EP_NO: N/A Repair Type: Non-Urgent EVAL Issue: Crossing Status: Found UCIP Comments: 04/08/2014 Unable to confirm crossing alignment and appurtenances associated with this crossing. Multiple stand pipes visible on landward side. Need to contact owner to determine status of crossing and alignment. (O. Magana - DWR UCIP) FIELD_STRUCT_DESC: 30-inch by 30-inch square reinforced concrete box drainage discharge culvert through the levee, 12.5 feet below the crown. Pump on the landside (LS). Concrete riser with slide gate on the waterside (WS) slope. Screw gate on the LS shoulder. (Plans to construct a new discharge structure and to rehabilitate one existing diversion structure to return intercepted seepage to the San Joaquin River authorized under Permit No. 13085, 1981 - Diener, Dry River Farms). [Additional Reference(s): DWR Levee Log, 2002 (HLM 4.05), listed as a 30-inch square reinforced concrete box culvert (RCBC)]. FS Date: 4/8/2014 | | | | | |

View of waterwar side.

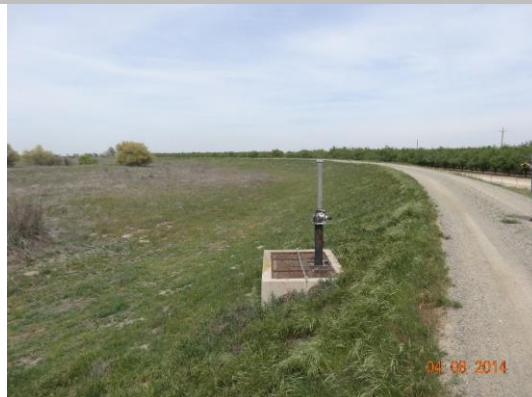
Photo 2 of 3 : UCIP_FA_2020_62213_67236.jpg

Slide gate inside concrete box located on waterward side.

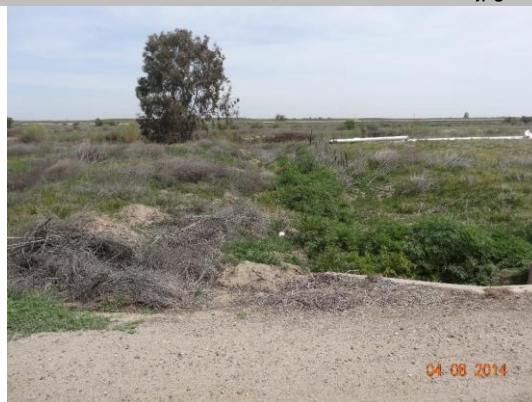
Photo 2 of 3 : UCIP_FA_2020_62215_60107.jpg

DS_ID:19957
FS_ID:62215
EP_NO: N/A
Repair Type: Non-Urgent
EVAL Issue:
Crossing Status: Found
UCIP Comments: 7/20/2016 same as previous inspection. Crossing has been downgraded from Urgent to Non-Urgent PVC does not prevent WS flap gate from closing. (O. Magana - DWR UCIP)4/08/2014 Unauthorized PVC pipe through existing crossing. PVC distorted inside--Need to contact owner to correct issue. If crossing was allowed need to contact owner for permit number issue for crossing variance. (O. Magana - DWR UCIP)
FIELD_STRUCT_DESC: 24-inch corrugated metal gravity drainage pipe through the levee, 3.6 feet below the crown. Flap gate on the waterside (WS) end. Concrete headwall on the landside (LS) end. Concrete U-shaped headwall on the WS end. [Additional Reference(s): DWR Levee Log, 2002 (HLM 6.72), listed as a 24-inch corrugated metal pipe (CMP)].
FS Date: 7/20/2016

View of WS--debris (pipe sections) located on waterward side.

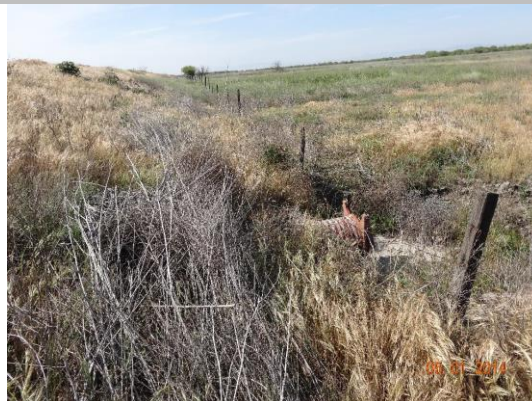
Photo 2 of 3 : UCIP_FA_2020_62225_67240.jpg

Pipe daylight visible on waterward toe.

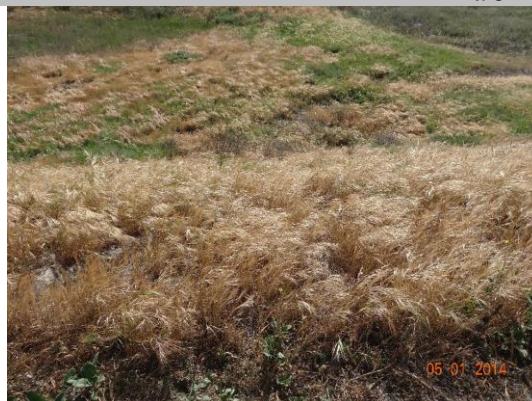
Photo 3 of 3 : UCIP_FA_2020_62225_67241.jpg

View of landward side--dense vegetation on landward side.

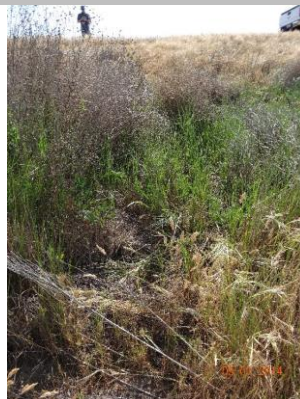
Photo 2 of 3 : UCIP_FA_2020_62221_67251.jpg

| visibility to identify signs of pipe failure (leaks) along the slope. | | | | | | |

View of waterward slope covered by dense vegetation.

| Recommend removing vegetation along pipe alignment to conduct | | | | | | |

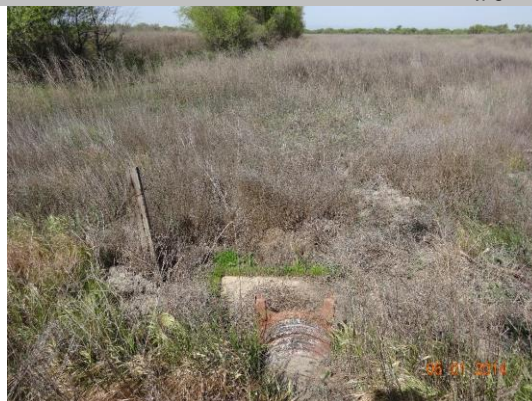
Photo 3 of 3 : UCIP_FA_2020_62221_67252.jpg

Pipe and flap gate visible on waterward side.

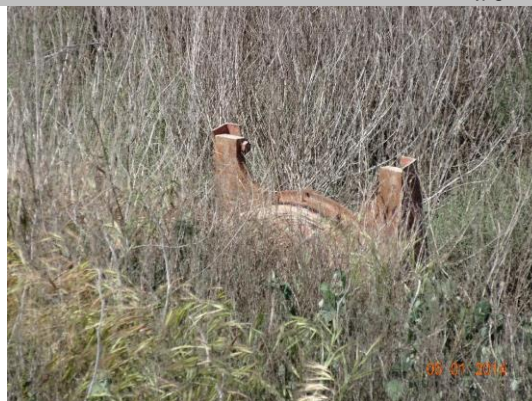
Photo 2 of 3 : UCIP_FA_2020_62222_67255.jpg

DS_ID:19968
 FS_ID:62222
 EP_NO: N/A
 Repair Type: Non-Urgent
 EVAL Issue:
 Crossing Status: Found
 UCIP Comments: 05/01/2014 Dense vegetation limits the inspectors visibility to identify signs of pipe failure (leaks) along the slope. Recommend removing vegetation along pipe alignment to conduct proper inspection of structure. (O. Magana - DWR UCIP)
 FIELD_STRUCT_DESC: 24-inch corrugated metal gravity drainage pipe through the levee, 11.4 feet below the crown. Flap gate on the waterside (WS) end. [Additional Reference(s): DWR Levee Log, 2002 (HLM 0.97), listed as a 24-inch corrugated metal pipe (CMP). USACE San Joaquin O&M Manual, Unit 601 Part 1 (SJR601.1), 1967, Revised 25 May 2011, (HLM 0.97), listed as a 24-inch CMP]
 FS Date: 5/1/2014

Pipe and evidence of flap gate visible on waterward side.

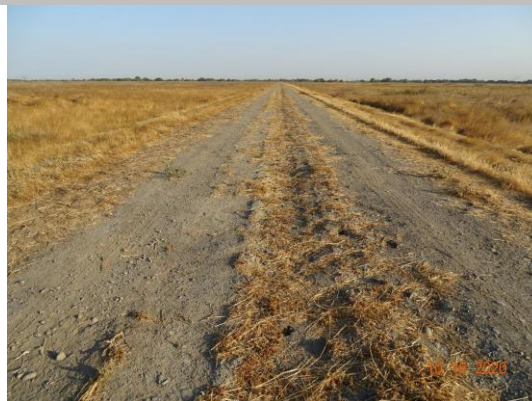
Photo 1 of 1 : FA_2020_NA0010_141_13_20201109_00019.jpg

Rutting in the levee crown. (Fall 2020)

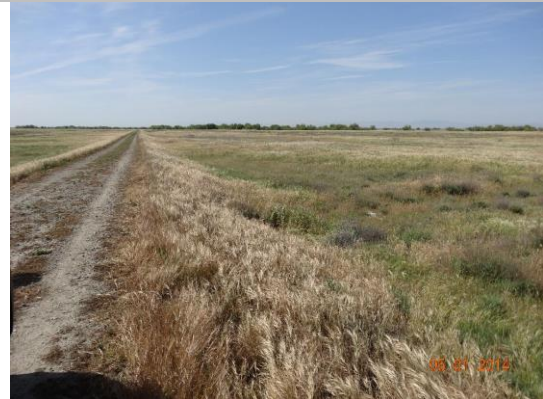
Photo 2 of 3 : UCIP_FA_2020_62223_67260.jpg

| DS_ID:19969 FS_ID:62223 EP_NO: N/A Repair Type: Non-Urgent EVAL Issue: Crossing Status: Found UCIP Comments: 05/01/2014 Dense vegetation limits the inspectors visibility to identify signs of pipe failure (leaks) along the slope. Recommend removing vegetation along pipe alignment to conduct proper inspection of structure. (O. Magana - DWR UCIP) FIELD_STRUCT_DESC: 24-inch corrugated metal gravity drainage pipe through the levee, 4 feet below the crown. Flap gate on the waterside (WS) end. [Additional Reference(s): DWR Levee Log, 2002 (HLM 2.05), listed as a 24-inch corrugated metal pipe (CMP). USACE San Joaquin O&M Manual, Unit 601 Part 1 (SJR601.1), 1967, Revised 25 May 2011, (HLM 2.05), listed as a 24-inch CMP] FS Date: 5/1/2014 | | | | | |

View of waterward side.

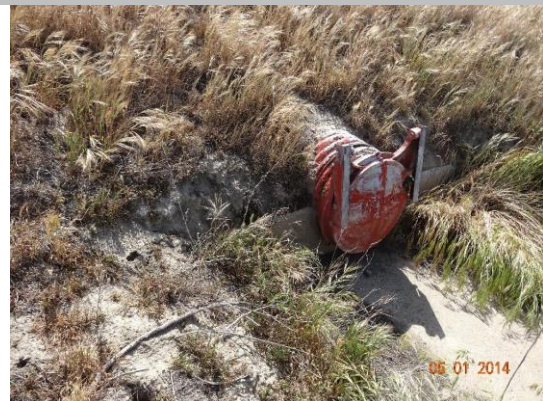
Photo 3 of 3 : UCIP_FA_2020_62223_67261.jpg

Flap gate and concrete headwall located on waterward toe.

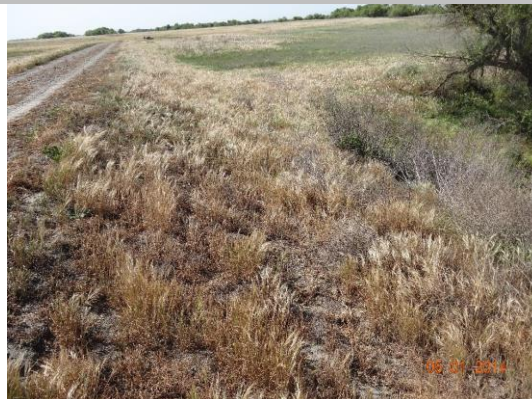
Photo 1 of 3 : UCIP_FA_2020_62224_67270.jpg

DS_ID:19970
FS_ID:62224
EP_NO: N/A
Repair Type: Non-Urgent
EVAL Issue:
Crossing Status: Found
UCIP Comments: 05/01/2014 Dense vegetation limits the inspectors visibility to identify signs of pipe failure (leaks) along the slope. Recommend removing vegetation along pipe alignment to conduct proper inspection of structure. Sediment buildup in pipe visible on landward side--recommend clearing. (O. Magana - DWR UCIP)
FIELD_STRUCT_DESC: 24-inch corrugated metal gravity drainage pipe through the levee, 11.2 feet below the crown. Flap gate on the waterside (WS) end. [Additional Reference(s): DWR Levee Log, 2002 (HLM 2.45), listed as a 24-inch corrugated metal pipe (CMP). USACE San Joaquin O&M Manual, Unit 601 Part 1 (SJR601.1), 1967, Revised 25 May 2011, (HLM 2.45), listed as a 24-inch CMP]
FS Date: 5/1/2014 4:04:00 PM

View of waterward side.

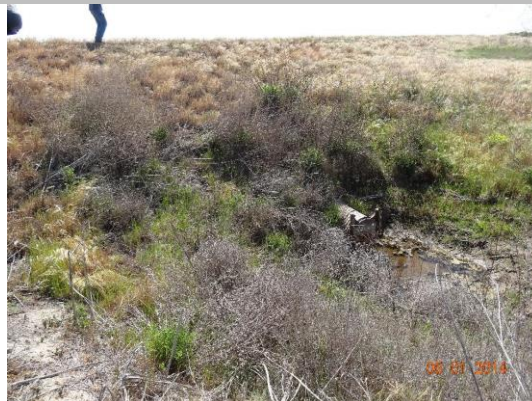
Photo 2 of 3 : UCIP_FA_2020_62224_67269.jpg

Pipe daylights at waterward toe.

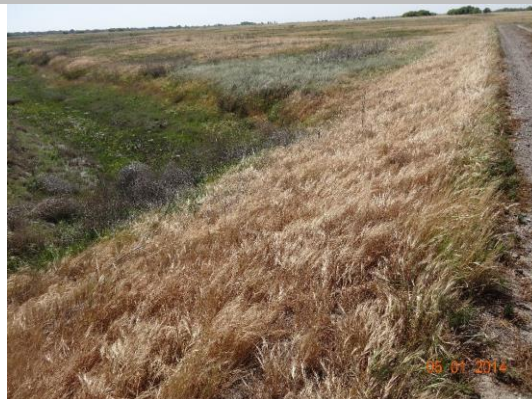
Photo 3 of 3 : UCIP_FA_2020_62224_67268.jpg

View of landward side.
