## Flood Control Project Maintenance Levee Inspections

### Fall 2021 Levee Maintenance Deficiency Summary Report

#### San Joaquin River Basin

NA0010 Lower San Joaquin Levee District	Overall LMA Rating	Total LMA Miles							
	U	191.27							
Rated Item	Maintenance Deficiency				Enforcement		Design & System Obsolescence		
	M Miles	U Miles	M + 4U Miles	Threshold %	M Miles	U Miles	M Miles	U Miles	
<i>Earthen Levee</i>									
Vegetation	47.00	9.57	85.28	44.59%					
Trim / Thin Trees	0.10		0.10	0.05%					
Encroachments	0.23	0.02	0.31	0.16%	9.29	0.59			
Animal Control	7.67	2.19	16.43	8.59%					
Slope Stability	0.05	0.01	0.09	0.05%					
Erosion / Bank Caving	0.13	0.81	3.37	1.76%					
Crown Surface / Depressions / Rutting	0.01		0.01	0.01%					
Repair Gates	0.02	0.02	0.10	0.05%					
<i>Rivers, Channels &amp; Designated Floodways</i>									
Encroachments					0.01	0.01			
<i>Supplemental</i>									
DWR Erosion Survey	0.12	0.17	0.80	0.42%					
DWR UCIP Field Study					1.29	0.05			
DWR UCIP LMA Responsibility									
<i>LMA Totals:</i>	55.33	12.79	106.49	55.67%	10.59	0.65	0.00	0.00

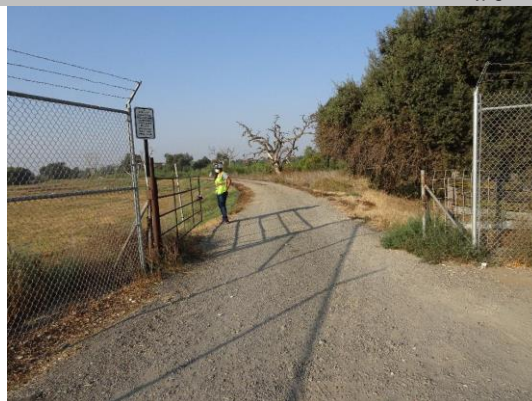
Photo 1 of 3 : UCIP\_FA\_2021\_64704\_92086.jpg

DS\_ID:19650  
FS\_ID:64704  
EP\_NO: N/A  
Repair Type: Non-Urgent  
EVAL Issue: Pipe Damage  
Crossing Status: Found  
UCIP Comments: 10/06/2020 Record remains Non-Urgent. DWR DMP has found integrity issues, LOF between 4 and 5. This crossing will be monitored until funding becomes available for rehabilitation. Dense vegetation was found along the LS and WS. No permit was found authorizing this encroachment. The CVFPB will need to review crossing to determine owner. (O. Magana - DWR UCIP, B. Singh - GEI)04/08/2014 Dense vegetation limits the inspector's visibility to identify signs of pipe failure (leaks) along the waterward slope and landward toe. Recommend removing vegetation along pipe alignment and landward toe to conduct proper inspection of structure and appurtenances. (W. Wylie - DWR UCIP)  
FIELD\_STRUCT\_DESC: 24-inch corrugated metal gravity drainage pipe through the levee, 10.5 feet below the crown. Flap gate on the waterside (WS) end. Brass cap No. 108 bench mark (BM) on the headwall on the landside (LS), elevation 65.1 feet, USGS Datum.

Overview of levee crown looking upstream towards pipe crossing. Pipe is located near gate entrance.

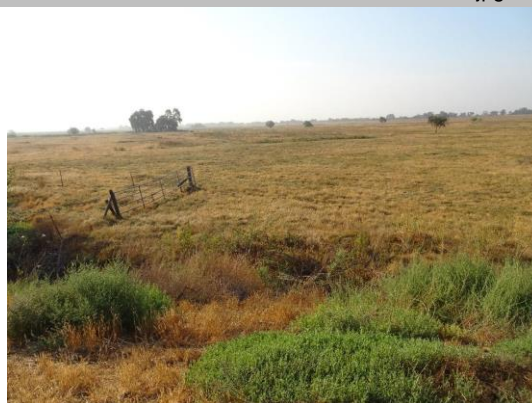
Photo 2 of 3 : UCIP\_FA\_2021\_64704\_92088.jpg

LS view: overview of LS, dense vegetation on slope and levee toe.

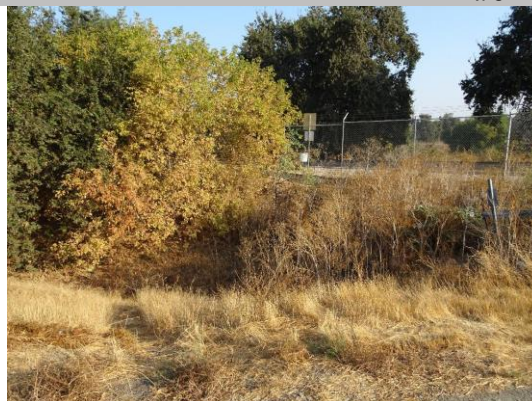
Photo 3 of 3 : UCIP\_FA\_2021\_64704\_92087.jpg

WS view: overview of WS, dense vegetation on slope and levee toe.

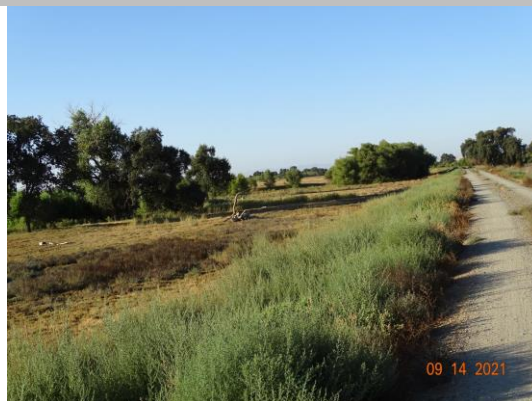
Photo 1 of 1 : FA\_2021\_NA0010\_118\_123\_20210927\_00292.jpg

LM Start	0.06	Rating **	M	Issue No.	123
LM End	0.28	Issue Type +	Ma	Location *	LS
Category	Earthen Levee			GPS Latitude/Longitude	
				Start	End
Item	Vegetation			37.348104 °	37.345415 °
				-120.959736 °	-120.961876 °
DWR ID	DWR_NA0010_01_f_2021_123				
Comment Code					
V1 : Control annual grass and weeds on the levee slopes and easements.					
Inspector Comment

View of vegetation on the landside slope looking upstream. (Fall 2021)

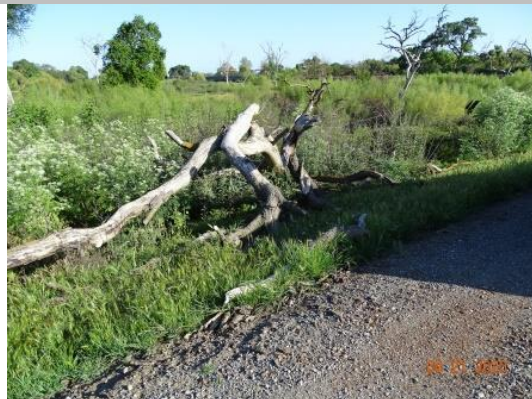
Photo 1 of 1 : FA\_2021\_NA0010\_118\_143\_20210830\_00023.jpg

LM Start	0.12	Rating **	M	Issue No.	143
LM End	0.12	Issue Type +	Ma	Location *	WS
Category	Earthen Levee			GPS Latitude/Longitude	
				Start	End
Item	Encroachments			37.347444 °	37.347444 °
				-120.960311 °	-120.960311 °
DWR ID	DWR_NA0010_01_s_2020_143				
Comment Code					
TR : Tree or limb					
Inspector Comment

Downed tree limb should be removed from the waterside shoulder.  
(Spring 2020)

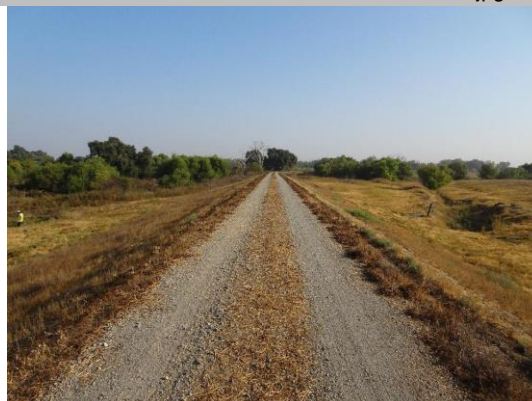
Photo 1 of 3 : UCIP\_FA\_2021\_64841\_90529.jpg

UCIP Comments: 10/06/2020 Record remains Non-Urgent. No permit was found authorizing this encroachment. Sediment buildup found on the LS. Recommend maintenance to clear up sediment buildup along pipe invert. CVFPB will need to review crossing to determine owner. DWR DMP internal inspection is pending and scheduled for 2021. (O. Magana - DWR UCIP, B. Singh - GEI)04/08/2014 Pipe has significant sediment buildup and shows some signs of corrosion at landward toe. Recommend cleaning sediment from inside pipe and check wall integrity. (W. Wylie - DWR UCIP)

Overview of levee looking US

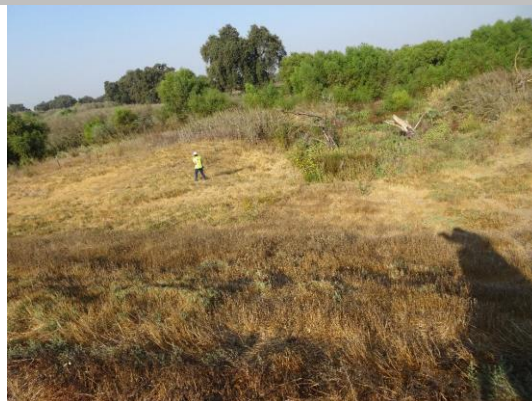
Photo 3 of 3 : UCIP\_FA\_2021\_64841\_90531.jpg

WS view: Overview of WS slope, looking US

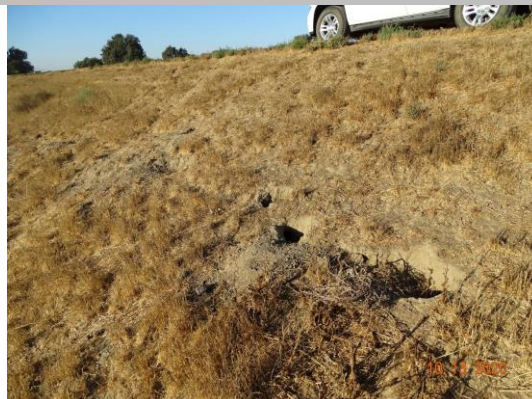
Photo 1 of 1 : FA\_2021\_NA0010\_118\_95\_20210830\_00006.jpg

LM Start	0.36	Rating **	M	Issue No.	95
LM End	0.36	Issue Type +	Ma	Location *	LS
Category	Earthen Levee			GPS Latitude/Longitude	
				Start	End
Item	Animal Control			37.344312 °	37.344312 °
				-120.962361 °	-120.962361 °
DWR ID	DWR_NA0010_01_f_2020_95				
Comment Code					
A3 : No rodents visible, but rodent burrows visible; need to backfill and compact or grout burrows.					
Inspector Comment

Several rodent holes observed in the landside slope. (Fall 2020)

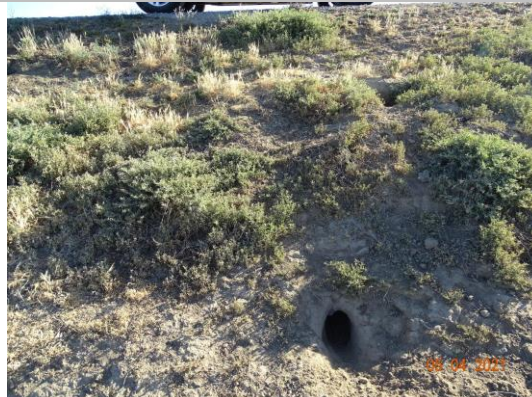
Photo 1 of 1 : FA\_2021\_NA0010\_118\_97\_20210830\_00007.jpg

LM Start	0.45	Rating **	M	Issue No.	97
LM End	0.45	Issue Type +	Ma	Location *	WS
Category	Earthen Levee			GPS Latitude/Longitude	
				Start	End
Item	Animal Control			37.343243 °	37.343243 °
				-120.962159 °	-120.962159 °
DWR ID	DWR_NA0010_01_s_2021_97				
Comment Code					
A1 : Exterminate rodents and backfill and compact or grout burrows.					
Inspector Comment

View of rodent burrows in the waterside slope. (Spring 2021)

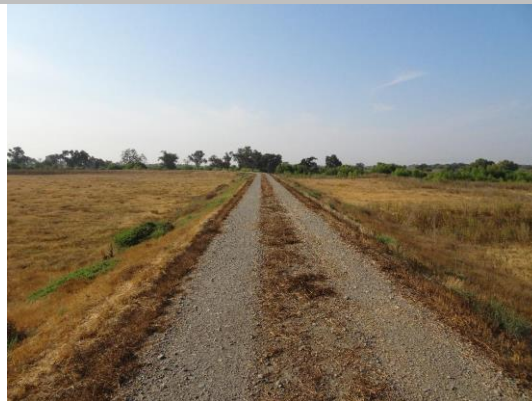
Photo 1 of 3 : UCIP\_FA\_2021\_64706\_90537.jpg

Comment Code						
Inspector Comment						
DS_ID:19583 FS_ID:64706 EP_NO: N/A Repair Type: Non-Urgent EVAL Issue: Unauthorized Encroachment, installed decades prior Crossing Status: Found UCIP Comments: 10/06/2020 Record remains Non-Urgent. No permit was found authorizing this encroachment. Rodent activity found near pipe location. CVFPB will need to review crossing to determine owner. DWR DMP has not found internal issues, LOF between 1 and 2. Recommend inspection in 5 years. (B. Singh - GEI, O. Magana - DWR UCIP)04/08/2014 Recommend removing vegetation pile from waterward toe. (W. Wylie - DWR UCIP) FIELD_STRUCT_DESC: 24-inch corrugated metal gravity drainage pipe through the levee, 8.5 feet below the crown. Flap gate on the waterside (WS) end. Brass cap No. 108 bench mark (BM) on the headwall on the landside (LS). [Additional Reference(s): DWR Levee Log, 2002 (HLM 0.62), listed as a 24-inch corrugated metal pipe (CMP). USACE San Joaquin O&M Manual, Unit 601 Part 1 (SJR601.1), 1967, Revised 25 May 2011, (HLM 0.62), listed as a 24-inch CMP]. FS Date: 10/6/2020

Overview of levee crown, looking US

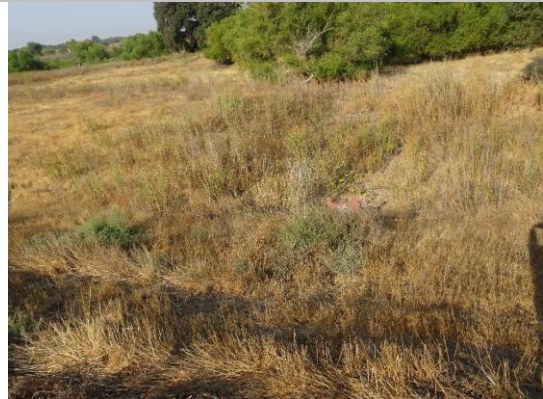
Photo 2 of 3 : UCIP\_FA\_2021\_64706\_90538.jpg

WS view: Flapgate and pipe visible on WS toe

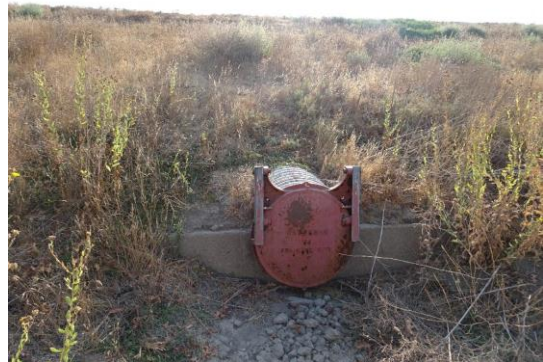
Photo 3 of 3 : UCIP\_FA\_2021\_64706\_90535.jpg

WS view: Flapgate and headwall at WS toe

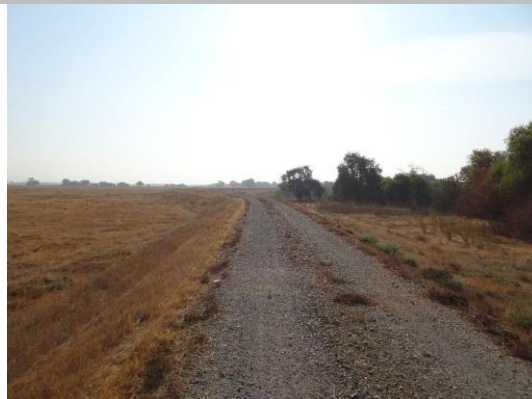
Photo 1 of 3 : UCIP\_FA\_2021\_64842\_90541.jpg

DS\_ID:19584  
FS\_ID:64842  
EP\_NO: N/A  
Repair Type: Non-Urgent  
EVAL Issue: Unauthorized Encroachment, installed decades prior  
Crossing Status: Found  
UCIP Comments: 10/06/2020 Record has been updated from No Action Needed to Non-Urgent. No permit was found authorizing this encroachment. CVFPB will need to review crossing to determine owner. Rodent activity found near this stretch of levee. DWR DMP has not found internal issues, LOF between 1 and 2. Recommend inspection in 5 years. (B. Singh - GEI, O. Magana - DWR UCIP)  
FIELD\_STRUCT\_DESC: 24-inch corrugated metal gravity drainage pipe through the levee, 7 feet below the crown. Flap gate on the waterside (WS) end. Brass cap No. 108 bench mark (BM) on the headwall on the landside (LS). [Additional Reference(s): DWR Levee Log, 2002 (HLM 0.88), listed as a 24-inch corrugated metal pipe (CMP). USACE San Joaquin O&M Manual, Unit 601 Part 1 (SJR601.1), 1967, Revised 25 May 2011, (HLM 0.87), listed as a 24-inch CMP].

Overview of levee crown, looking US

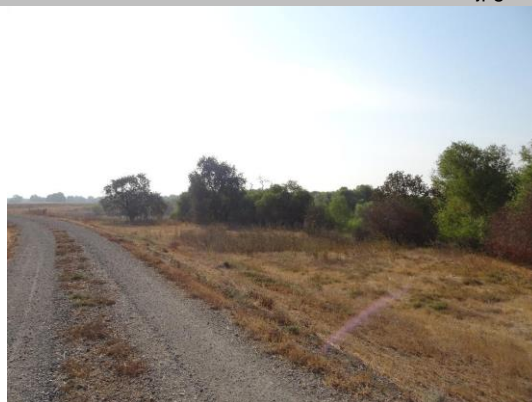
Photo 2 of 3 : UCIP\_FA\_2021\_64842\_92306.jpg

WS view: overview of WS looking upstream towards pipe crossing.

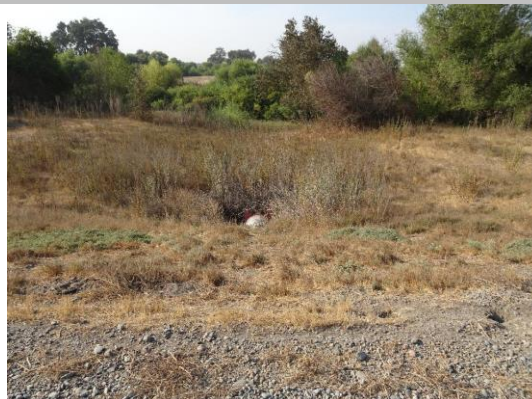
Photo 3 of 3 : UCIP\_FA\_2021\_64842\_90542.jpg

WS view: Flapgate and pipe visible on WS toe

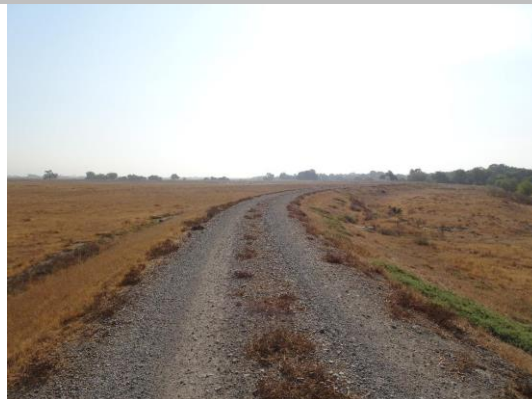
Photo 1 of 3 : UCIP\_FA\_2021\_64843\_90550.jpg

DS\_ID:19585  
 FS\_ID:64843  
 EP\_NO: N/A  
 Repair Type: Urgent  
 EVAL Issue: Pipe Integrity  
 Crossing Status: Found  
 UCIP Comments: 10/06/2020 Record has been updated from Non-Urgent to Urgent. DWR DMP has found integrity issues, LOF between 5 and 6. Scour visible behind the concrete headwall on the LS toe. Recommend monitoring crossing until funding becomes available to addressed. No permit was found authorizing this encroachment. CVFPB will need to review crossing to determine owner. (B. Singh - GEI, O. Magana - DWR UCIP)04/08/2014 Moderate erosion around headwall on landward toe. May or may not be an issue. Need to contact owner to determine status of crossing and to address erosion issue on landward side. (W. Wylie - DWR UCIP)  
 FIELD\_STRUCT\_DESC: 24-inch corrugated metal gravity drainage pipe through the levee, 9 feet below the crown. Flap gate on the waterside (WS) end. Brass cap No. 108 bench mark (BM) on the headwall on the landside (LS). [Additional Reference(s): DWR Levee Log, 2002 (HLM 0.96), listed as a 24-inch corrugated metal pipe (CMP). USACE San Joaquin O&M Manual, Unit 601 Part 1 (SJR601.1), 1967, Revised 25 May 2011, (HLM 0.95), listed as a 24-inch CMP].

Overview of levee crown, looking US

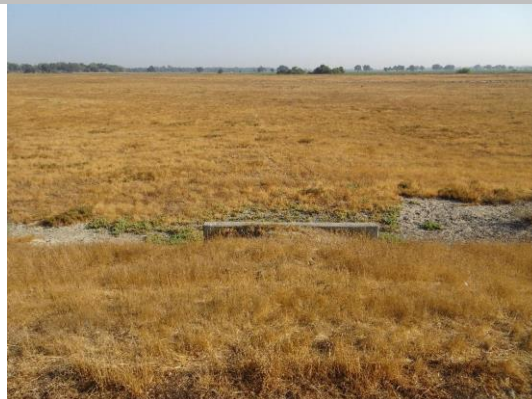
Photo 2 of 3 : UCIP\_FA\_2021\_64843\_90552.jpg

LS view: Headwall visible on LS toe

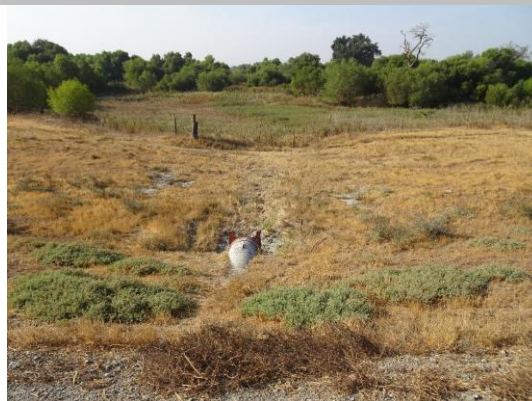
Photo 3 of 3 : UCIP\_FA\_2021\_64843\_90551.jpg

WS view: Flapgate, headwall, and pipe visible on WS toe

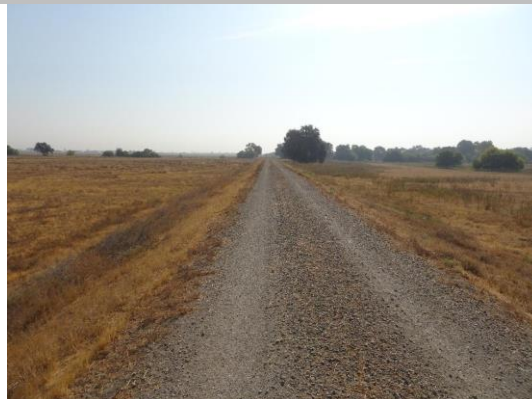
Photo 1 of 3 : UCIP\_FA\_2021\_64699\_90554.jpg

DS\_ID:19586  
FS\_ID:64699  
EP\_NO: N/A  
Repair Type: Non-Urgent  
EVAL Issue: Unauthorized Encroachment, installed decades prior  
Crossing Status: Found  
UCIP Comments: 10/06/2020 Record has been updated from No Action Needed to Non-Urgent. No permit was found authorizing this encroachment. CVFPB will need to review crossing to determine owner. DWR DMP has not found internal issues, LOF between 1 and 2. Recommend inspection in 5 years. (B. Singh - GEI, O. Magana - DWR UCIP)  
FIELD\_STRUCT\_DESC: 24-inch corrugated metal gravity drainage pipe through the levee, 7.5 feet below the crown. Flap gate on the waterside (WS) end. Brass cap No. 108 bench mark (BM) on the headwall on the landside (LS). [Additional Reference(s): DWR Levee Log, 2002 (HLM 1.18), listed as a 24-inch corrugated metal pipe (CMP). USACE San Joaquin O&M Manual, Unit 601 Part 1 (SJR601.1), 1967, Revised 25 May 2011, (HLM 1.17), listed as a 24-inch CMP].

Overview of levee crown, looking US

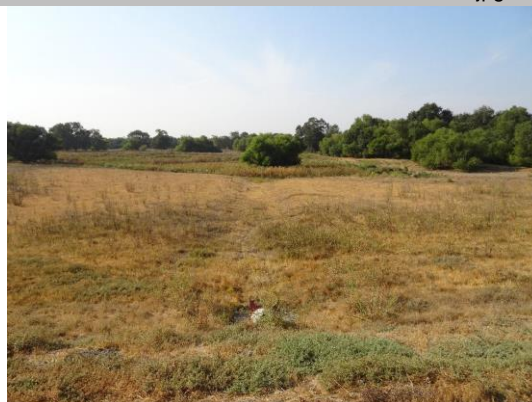
Photo 2 of 3 : UCIP\_FA\_2021\_64699\_90555.jpg

Pipe and flapgate visible on WS toe

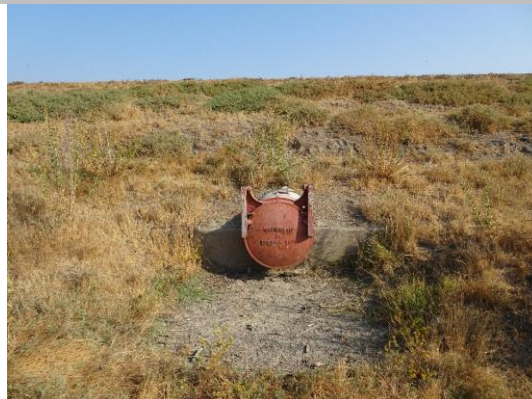
Photo 3 of 3 : UCIP\_FA\_2021\_64699\_90553.jpg

Pipe, flapgate and headwall on WS toe

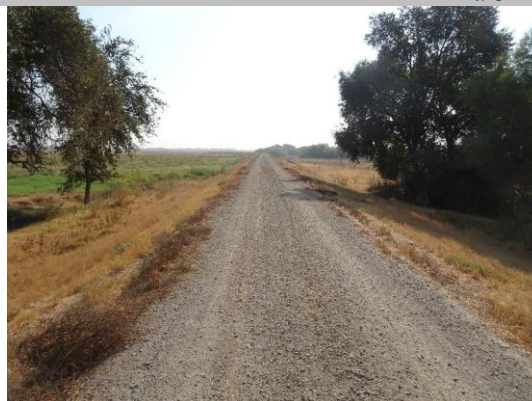
Photo 1 of 3 : UCIP\_FA\_2021\_64700\_90560.jpg

DS\_ID:19587  
 FS\_ID:64700  
 EP\_NO: N/A  
 Repair Type: Non-Urgent  
 EVAL Issue: Unauthorized Encroachment, installed decades prior  
 Crossing Status: Found  
 UCIP Comments: 10/06/2020 Record has been updated from No Action Needed to Non-Urgent. No permit was found authorizing this encroachment. CVFPB will need to review crossing to determine owner. DWR DMP internal inspection is still pending and scheduled for 2021. (B. Singh - GEI, O. Magana - DWR UCIP)  
 FIELD\_STRUCT\_DESC: 36-inch corrugated metal gravity drainage pipe through the levee, 12.8 feet below the crown. Flap gate on the waterside (WS) end. Brass cap No. 108 bench mark (BM) on the headwall on the landside (LS). Pipe crosses through the levee at about a 45 degree angle to the crown. [Additional Reference(s): DWR Levee Log, 2002 (HLM 1.35), listed as a 36-inch corrugated metal pipe. USACE San Joaquin O&M Manual, Unit 601 Part 1 (SJR601.1), 1967, Revised 25 May 2011, (HLM 1.34), listed as a 36-inch CMP].

Overview of levee crown, looking US

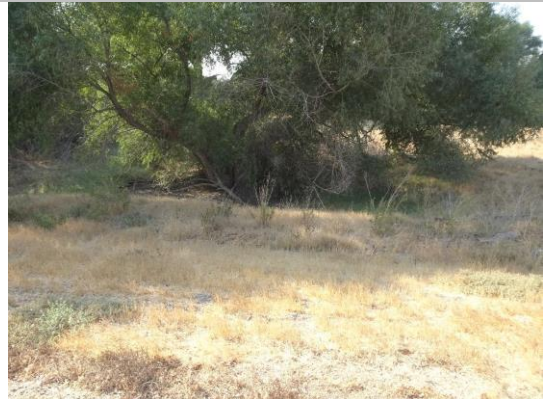
Photo 2 of 3 : UCIP\_FA\_2021\_64700\_90565.jpg

WS view: Overview of WS from levee crown. Headwall not visible from levee crown

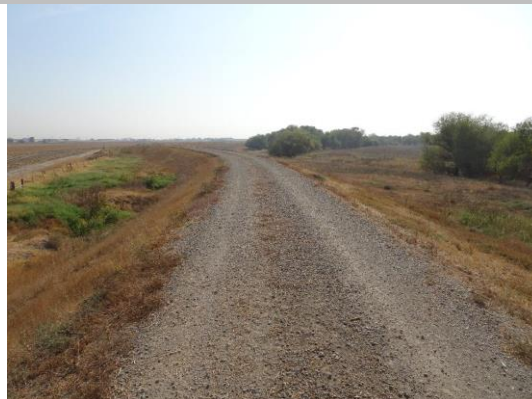
Photo 1 of 3 : UCIP\_FA\_2021\_64701\_90567.jpg

Comment Code						
Inspector Comment						
DS_ID:19588 FS_ID:64701 EP_NO: N/A Repair Type: Non-Urgent EVAL Issue: Unauthorized Encroachment, installed decades prior Crossing Status: Found UCIP Comments: 10/06/2020 Record remains Non-Urgent. No permit was found authorizing this encroachment. CVFPB will need to review crossing to determine owner. DWR DMP has not found internal issues, LOF between 1 and 2. Recommend inspection in 5 years. (B. Singh - GEI, O. Magana - DWR UCIP)04/08/2014 Some sediment buildup inside pipe at LS toe. Recommend contacting owner to clear sediment buildup and check wall integrity through pipe section. (W. Wylie - DWR UCIP) FIELD_STRUCT_DESC: 24-inch corrugated metal gravity drainage pipe through the levee, 11 feet below the crown. Flap gate on the waterside (WS) end. Brass cap No. 108 bench mark (BM) on the headwall on the landside (LS). [Additional Reference(s): DWR Levee Log, 2002 (HLM 1.48), listed as a 24-inch corrugated metal pipe (CMP). USACE San Joaquin O&M Manual, Unit 601 Part 1 (SJR601.1), 1967, Revised 25 May 2011, (HLM 1.48), listed as a 24-inch CMP]. FS Date: 10/6/2020

Overview of levee crown, looking US

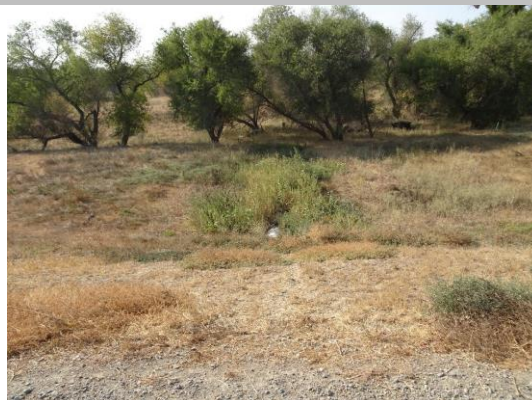
Photo 2 of 3 : UCIP\_FA\_2021\_64701\_90568.jpg

Pipe and flapgate visible on WS toe

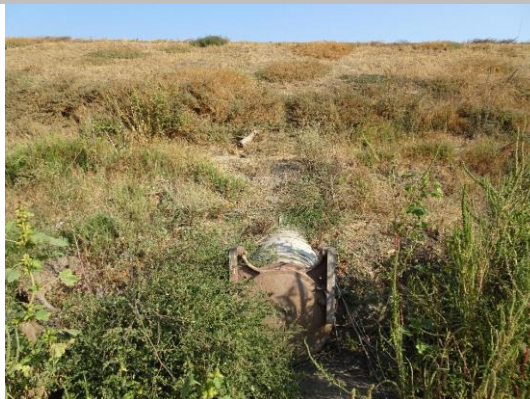
Photo 3 of 3 : UCIP\_FA\_2021\_64701\_90570.jpg

Pipe and flapgate visible on WS toe

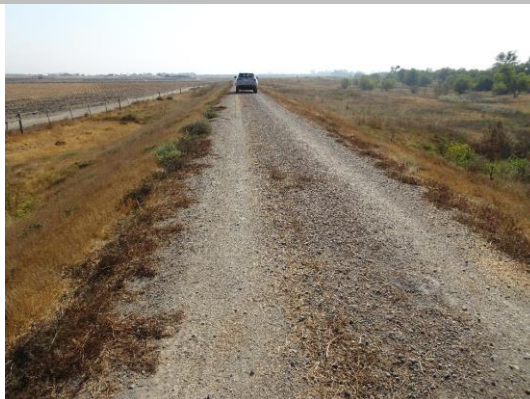
Photo 1 of 3 : UCIP\_FA\_2021\_64844\_90572.jpg

DS\_ID:19589  
FS\_ID:64844  
EP\_NO: N/A  
Repair Type: Non-Urgent  
EVAL Issue: Pipe Damage  
Crossing Status: Found  
UCIP Comments: 10/06/2020 Record remains Non-Urgent. DWR DMP has found integrity issues, LOF between 4 and 5. Crossing will be monitored until funding becomes available for rehabilitation. No permit was found authorizing this encroachment. CVFPB will need to review crossing to determine owner. Dense vegetation was found along the WS and LS toe. Recommend removing vegetation along the pipe alignment. Based on the 2014 photos, the LS toe appears to be heavily silted up. Recommend removing silt to increase flow capacity and meet pipe design capacity. (B. Singh - GEI, O. Magana - DWR UCIP)04/08/2014 Heavy sediment buildup in pipe at LS toe. (DWR UCIP - W. Wylie)  
FIELD\_STRUCT\_DESC: 24-inch corrugated metal gravity drainage pipe through the levee, 13.6 feet below the crown. Flap gate on the waterside (WS) end. Brass cap No. 108 bench mark (BM) on the headwall on the landside (LS). [Additional Reference(s): DWR Levee Log, 2002 (HLM 1.70), listed as a 24-inch corrugated metal pipe (CMP). USACE San Joaquin O&M Manual, Unit 601 Part 1 (SJR601.1), 1967, Revised 25 May 2011, (HLM 1.69), listed as a 24-inch CMP].

Overview of levee crown, looking US

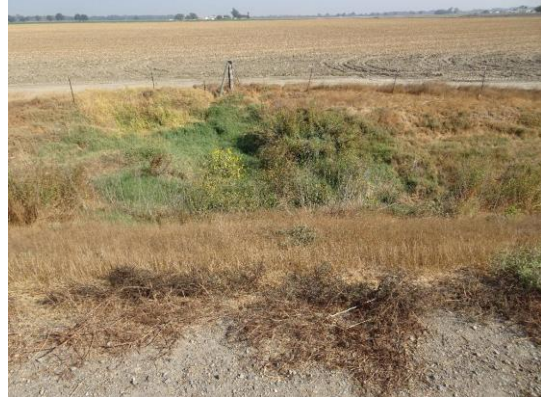
Photo 2 of 3 : UCIP\_FA\_2021\_64844\_90573.jpg

LS view: Pipe and headwall not visible on LS toe from levee crown

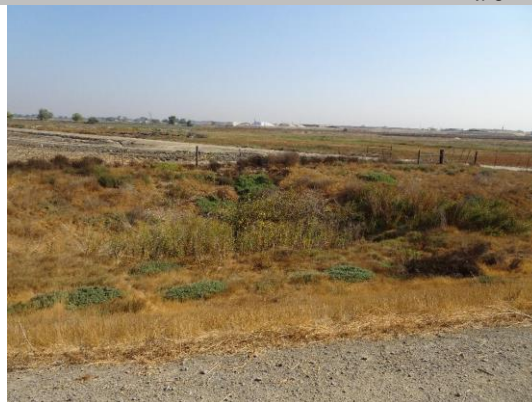
Photo 2 of 3 : UCIP\_FA\_2021\_64845\_90583.jpg

LS view: Pipe and headwall are not visible at LS toe from levee crown

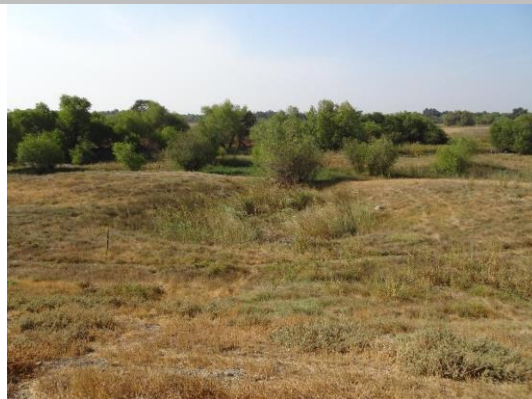
Photo 3 of 3 : UCIP\_FA\_2021\_64845\_90582.jpg

WS view: Pipe, flapgate, and headwall are not visible at WS toe from levee crown

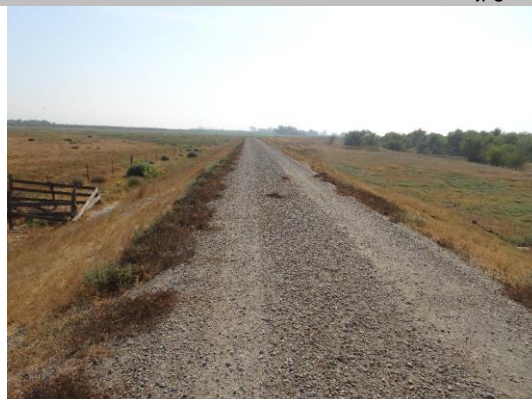
Photo 1 of 3 : UCIP\_FA\_2021\_64707\_90611.jpg

DS\_ID:19591  
FS\_ID:64707  
EP\_NO: N/A  
Repair Type: Non-Urgent  
EVAL Issue: Unauthorized Encroachment, installed decades prior  
Crossing Status: Found  
UCIP Comments: 10/06/2020 Record remains Non-Urgent. Rodent activity found in the general area. No permit was found authorizing this encroachment. CVFPB will need to review crossing to determine owner. DWR DMP has not found internal issues, LOF between 1 and 2. Recommend inspection in 5 years. (B. Singh - GEI, O. Magana - DWR UCIP)04/08/2014 Need to contact owner to determine crossing status. Inlet drop box silted in and needs to be cleaned out. (W. Wylie - DWR UCIP)  
FIELD\_STRUCT\_DESC: 24-inch corrugated metal gravity drainage pipe through the levee, 9.7 feet below the crown. Flap gate on the waterside (WS) end. Brass cap No. 100 bench mark (BM) on the headwall on the landside (LS). Wooden barrier around drop inlet on the LS toe. [Additional Reference(s): DWR Levee Log, 2002 (HLM 1.98), listed as a 24-inch corrugated metal pipe (CMP). USACE San Joaquin O&M Manual, Unit 601 Part 1 (SJR601.1), 1967, Revised 25 May 2011, (HLM 1.98), listed as a 24-inch CMP].

Overview of levee crown, looking US

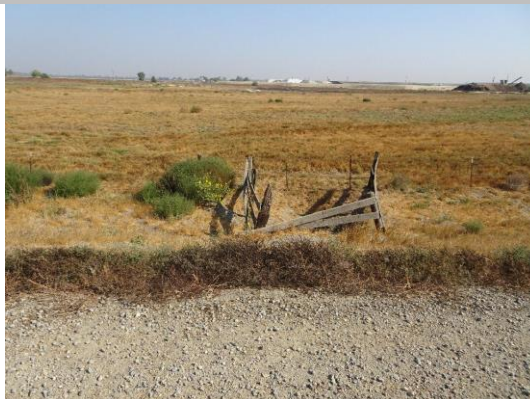
Photo 2 of 3 : UCIP\_FA\_2021\_64707\_90613.jpg

LS view: View toward LS pipe and headwall from levee crown

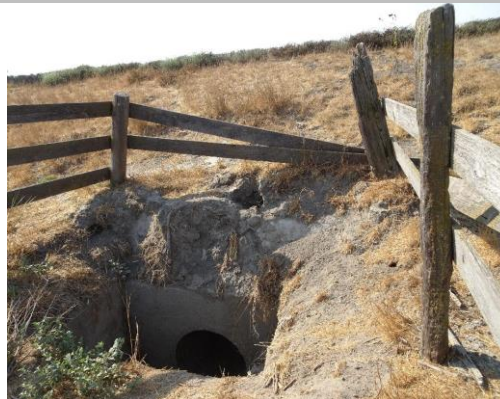
Photo 3 of 3 : UCIP\_FA\_2021\_64707\_90615.jpg

LS view: Pipe and headwall at LS toe

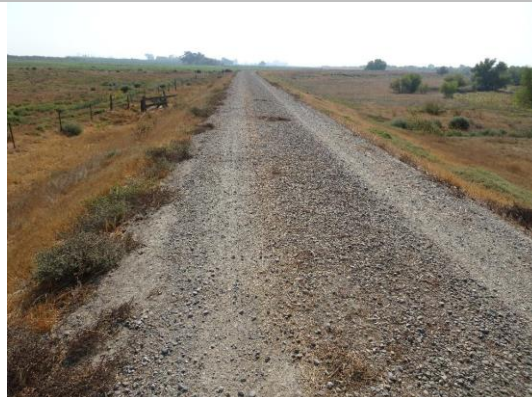
Photo 1 of 3 : UCIP\_FA\_2021\_64708\_90617.jpg

Comment Code						
Inspector Comment						
DS_ID:19570 FS_ID:64708 EP_NO: N/A Repair Type: Non-Urgent EVAL Issue: Pipe Damage Crossing Status: Found UCIP Comments: 10/06/2020 Record remains Non-Urgent. DWR DMP has found integrity issues, LOF between 4 and 5. Recommend monitoring pipe crossing until funding becomes available for rehabilitation. Wooden barrier surrounding drop-inlet is dilapidated. No permit was found authorizing this encroachment. CVFPB will need to review crossing to determine owner. (B. Singh - GEI, O. Magana - DWR UCIP)04/08/2014 Unable to find inlet on landward toe. Recommend clearing vegetation on landward side to properly inspect inlet. (W. Wylie - DWR UCIP) FIELD_STRUCT_DESC: 24-inch corrugated metal gravity drainage pipe through the levee, 9.8 feet below the crown. Flap gate on the waterside (WS) end. Brass cap No. 100 bench mark (BM) on the headwall on the landside (LS). [Additional Reference(s): DWR Levee Log, 2002 (HLM 2.08), listed as a 24-inch corrugated metal pipe (CMP). USACE San Joaquin O&M Manual, Unit 601 Part 1 (SJR601.1), 1967, Revised 25 May 2011, (HLM 2.08), listed as a 24-inch CMP]. FS Date: 10/6/2020

Overview of levee crown, looking US

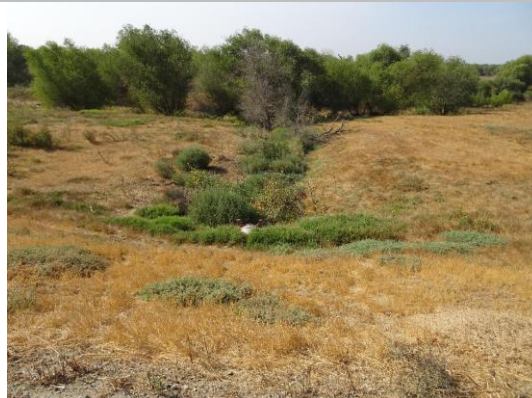
Photo 2 of 3 : UCIP\_FA\_2021\_64708\_90618.jpg

WS view: Pipe and flapgate visible on WS toe

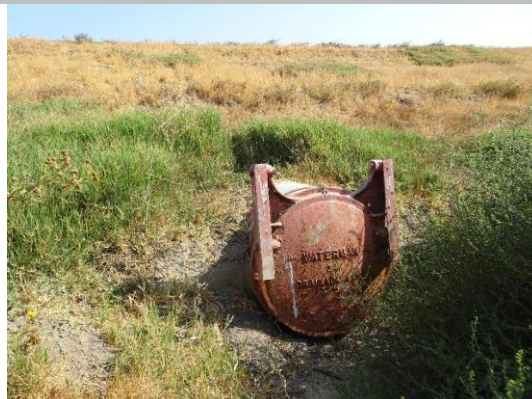
Photo 3 of 3 : UCIP\_FA\_2021\_64708\_90620.jpg

WS view: Pipe, flapgate, and headwall on WS toe

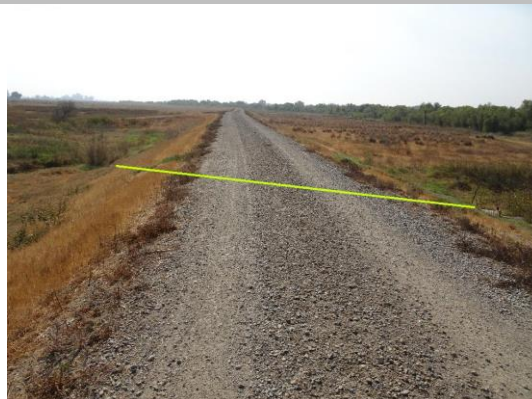
Photo 1 of 3 : UCIP\_FA\_2021\_64709\_90625.jpg

Comment Code						
Inspector Comment						
DS_ID:19571 FS_ID:64709 EP_NO: N/A Repair Type: Non-Urgent EVAL Issue: Unauthorized Encroachment, installed decades prior Crossing Status: Found UCIP Comments: 10/06/2020 Record has been updated from No Action Needed to Non-Urget. Pipe angle through the levee. System description has been updated. No permit was found authorizing this encroachment. CVFPB will need to review crossing to determine owner. DWR DMP internal inspection is pending and scheduled for 2021. (B. Singh - GEI, O. Magana - DWR UCIP) FIELD_STRUCT_DESC: 36-inch corrugated metal gravity drainage pipe through the levee at an angle, 12.6 feet below the crown. Flap gate on the waterside (WS) end. Brass cap No. 100 bench mark (BM) on the headwall on the landside (LS). Wooden barrier around drop inlet on the LS toe. [Additional Reference(s): DWR Levee Log, 2002 (HLM 2.25), listed as a 36-inch corrugated metal pipe (CMP). USACE San Joaquin O&M Manual, Unit 601 Part 1 (SJR601.1), 1967, Revised 25 May 2011, (HLM 2.25), listed as a 36-inch CMP]. FS Date: 10/6/2020

Overview of levee crown, looking US. Pipe angled through levee at alignment shown

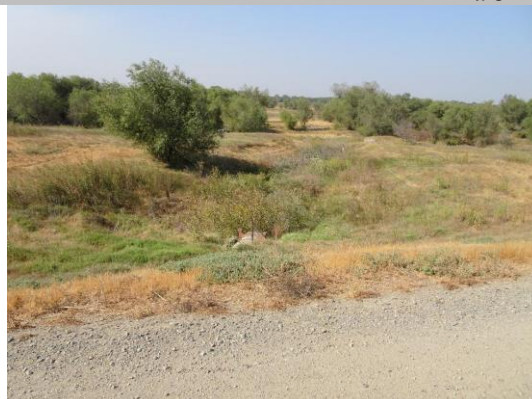
Photo 2 of 3 : UCIP\_FA\_2021\_64709\_90626.jpg

WS view: Pipe and flapgate visible on WS toe

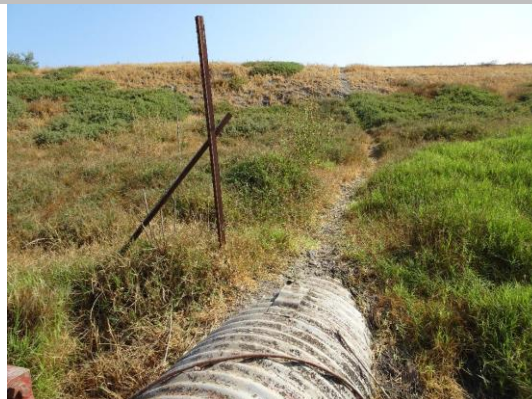
Photo 3 of 3 : UCIP\_FA\_2021\_64709\_90629.jpg

WS view: Pipe and slope on WS toe

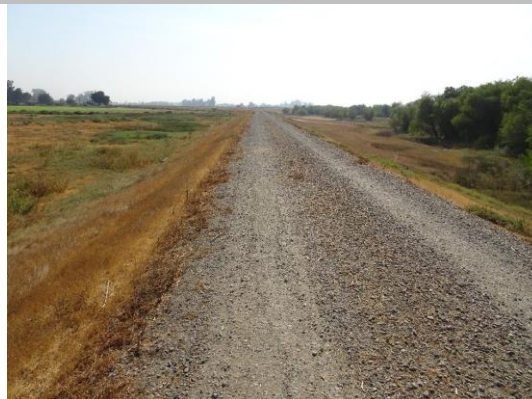
Photo 1 of 3 : UCIP\_FA\_2021\_64710\_90632.jpg

DS\_ID:19572  
 FS\_ID:64710  
 EP\_NO: N/A  
 Repair Type: Non-Urgent  
 EVAL Issue: Unauthorized Encroachment, installed decades prior  
 Crossing Status: Found  
 UCIP Comments: 10/06/2020 Record has been updated from No Action Needed to Non-Urgent. No permit was found authorizing this encroachment. CVFPB will need to review crossing to determine owner. DWR DMP has not found internal issues, LOF between 1 and 2. Recommend inspection in 5 years. (B. Singh - GEI, O. Magana - DWR UCIP)  
 FIELD\_STRUCT\_DESC: 24-inch corrugated metal gravity drainage pipe through the levee, 8 feet below the crown. Flap gate on the waterside (WS) end. Brass cap No. 100 bench mark (BM) on the headwall on the landside (LS). [Additional Reference(s): DWR Levee Log, 2002 (HLM 2.53), listed as a 24-inch corrugated metal pipe (CMP). USACE San Joaquin O&M Manual 601.1, 1967, (HLM 2.52), listed as 24-inch CMP].  
 FS Date: 10/6/2020

Overview of levee crown, looking US

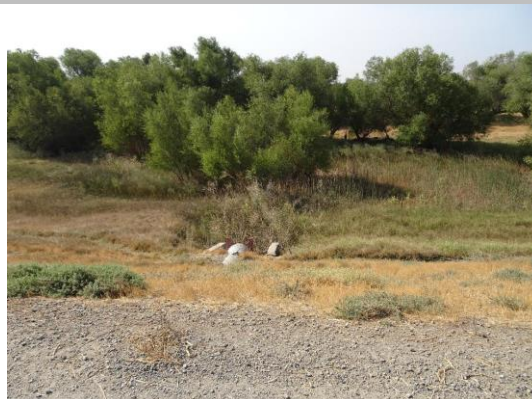
Photo 2 of 3 : UCIP\_FA\_2021\_64710\_90633.jpg

WS view: Pipe, headwall, and flapgate visible on WS toe

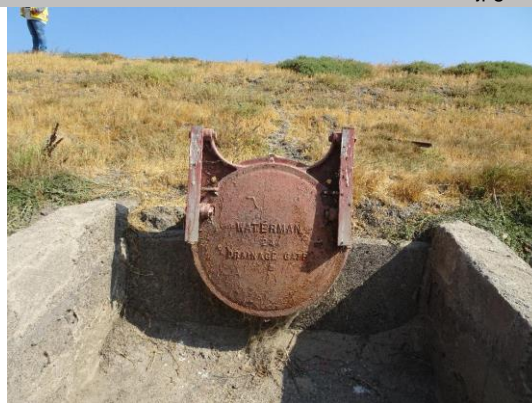
Photo 3 of 3 : UCIP\_FA\_2021\_64710\_90635.jpg

WS view: Pipe, flapgate, and headwall on WS toe

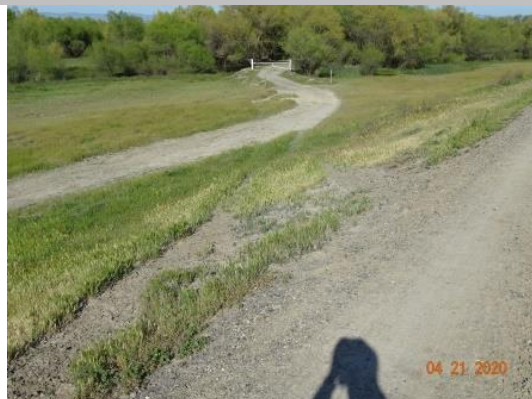
Photo 1 of 1 : FA\_2021\_NA0010\_118\_113\_20210830\_00015.jpg

LM Start	2.58	Rating **	A/W	Issue No.	113
LM End	2.58	Issue Type +	Ma	Location *	WS
Category	Earthen Levee			GPS Latitude/Longitude	
				Start	End
Item	Slope Stability			37.327936 °	37.327936 °
				-120.933013 °	-120.933013 °
DWR ID	DWR_NA0010_01_f_2018_113				
Comment Code					
S3 : Repair the levee slope damaged by vehicle traffic and prevent access where possible.					
Inspector Comment					
There is damage caused by vehicle traffic over the levee.

Slope damage by vehicle traffic. (Spring 2020)

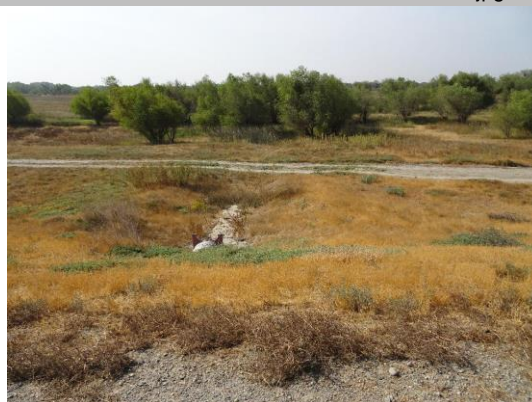
Photo 2 of 3 : UCIP\_FA\_2021\_64711\_90638.jpg

WS view: Pipe and flapgate visible on WS toe

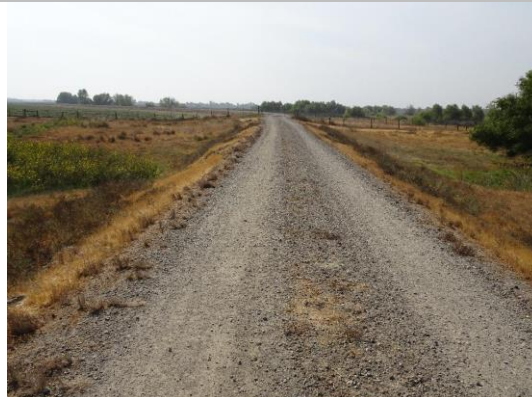
Photo 1 of 3 : UCIP\_FA\_2021\_64712\_90644.jpg

Comment Code					
Inspector Comment					
DS_ID:19574 FS_ID:64712 EP_NO: N/A Repair Type: Non-Urgent EVAL Issue: Unauthorized Encroachment, installed decades prior Crossing Status: Found UCIP Comments: 10/06/2020 Record remains Non-Urgent. No permit was found authorizing this encroachment. CVFPB will need to review crossing to determine owner. DWR DMP internal inspection is pending and scheduled for 2021. (B. Singh - GEI, O. Magana - DWR UCIP)04/08/2014 Some minor erosion around headwall on LS toe. (W. Wylie - DWR UCIP) FIELD_STRUCT_DESC: 36-inch corrugated metal gravity drainage pipe through the levee, 8 feet below the crown. Flap gate on the waterside (WS) end. Brass cap No. 100 bench mark (BM) on the headwall on the landside (LS). [Additional Reference(s): DWR Levee Log, 2002 (HLM 3.17), listed as a 36-inch corrugated metal pipe (CMP). USACE San Joaquin O&M Manual, Unit 601 Part 1 (SJR601.1), 1967, Revised 25 May 2011, (HLM 3.16), listed as a 36-inch CMP]. FS Date: 10/6/2020

Overview of levee crown, looking US

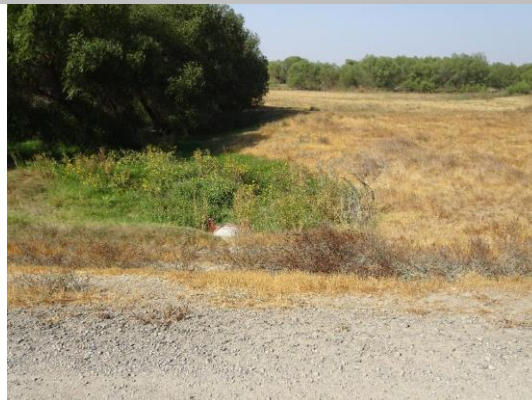
Photo 2 of 3 : UCIP\_FA\_2021\_64712\_90645.jpg

WS view: Pipe and flapgate visible at WS toe

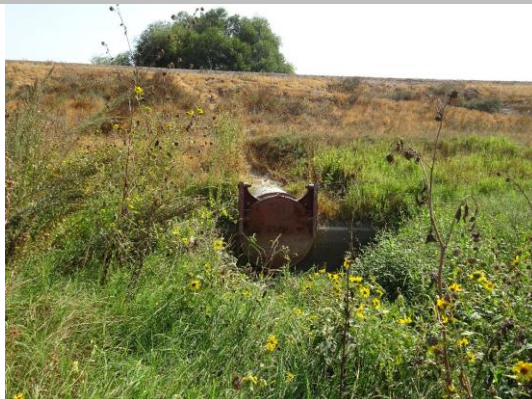
Photo 3 of 3 : UCIP\_FA\_2021\_64712\_90646.jpg

WS view: Pipe, flapgate, and headwall at WS toe

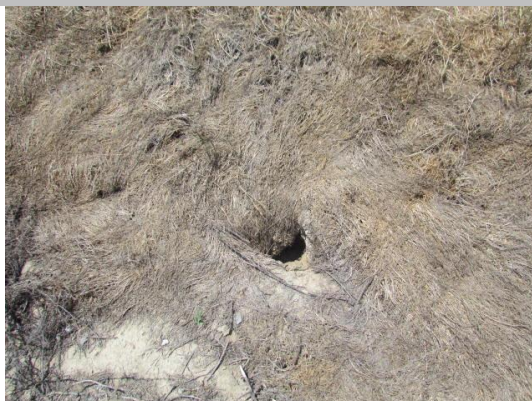
Photo 1 of 1 : FA\_2021\_NA0010\_118\_10\_20210830\_00004.jpg

LM Start	3.16	Rating **	A/W	Issue No.	10
LM End	3.16	Issue Type +	Ma	Location *	LS
Category	Earthen Levee			GPS Latitude/Longitude	
				Start	End
Item	Animal Control			37.321053 °	37.321053 °
				-120.928785 °	-120.928785 °
DWR ID	DWR_NA0010_01_s_2012_10				
Comment Code					
A3 : No rodents visible, but rodent burrows visible; need to backfill and compact or grout burrows.					
Inspector Comment

Looking at typical view of rodent holes on landward slope.

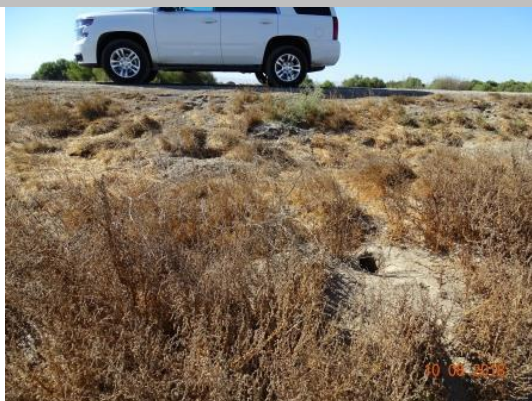
Photo 1 of 1 : FA\_2021\_NA0010\_118\_116\_20210830\_00018.jpg

LM Start	3.18	Rating **	M	Issue No.	116
LM End	3.18	Issue Type +	Ma	Location *	LS
Category	Earthen Levee			GPS Latitude/Longitude	
				Start	End
Item	Animal Control			37.320725 °	37.320725 °
				-120.928837 °	-120.928837 °
DWR ID	DWR_NA0010_01_f_2018_116				
Comment Code					
A3 : No rodents visible, but rodent burrows visible; need to backfill and compact or grout burrows.					
Inspector Comment					
Several rodent holes noted in this section.

View of landside slope with rodent holes. (Fall 2018)

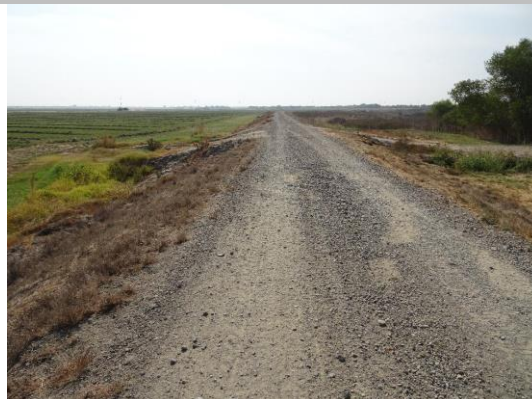
Photo 1 of 3 : UCIP\_FA\_2021\_64713\_90588.jpg

Comment Code						
Inspector Comment						
DS_ID:19575 FS_ID:64713 EP_NO: N/A Repair Type: Urgent EVAL Issue: Pipe Integrity Crossing Status: Found UCIP Comments: 10/06/2020 Record remains Urgent. Sinkhole present directly above the LS headwall and along pipe alignment. Pipe collapse visible from from the LS toe. Erosion present on the WS just behind the flap gate. No permit was found authorizing this encroachment. CVFPB will need to review crossing to determine owner. DWR DMP internal inspection is pending and scheduled in 2021. (B. Singh - GEI, O. Magana - DWR UCIP)11/01/2018 Pipe continues to rust through, causing the pipe to collapse on the LS. Sediment buildup visible from the LS inlet. Loss of soil just above the LS concrete headwall and along the LS slope. Crossing remains Urgent due to the levee slope issues and pipe failure through the levee. (O. Magana - DWR UCIP)07/19/2016 Same as previous inspection. Erosion present on LS slope. (O. Magana - DWR UCIP)04/08/2014 Pipe rusted through at Springline on LS toe. Flapgate blocked by sediment on WS toe. Heavy sediment on both ends of pipe. Need to contact owner to address issues. (W. Wylie - DWR UCIP) FIELD_STRUCT_DESC: 36-inch corrugated metal gravity drainage pipe through the levee, 9.7 feet below the crown. Flap gate on the waterside (WS) end. Brass cap No. 100 bench mark (BM) on the headwall on the landside (LS). [Additional Reference(s): DWR Levee Log, 2002 (HLM 3.50), listed as a 36-inch corrugated metal pipe (CMP). USACE San Joaquin O&M Manual, Unit 601 Part 1 (SJR601.1), 1967, Revised 25 May 2011, (HLM 3.50), listed as a 36-inch CMP]. FS Date: 10/6/2020

Overview of levee crown, looking US

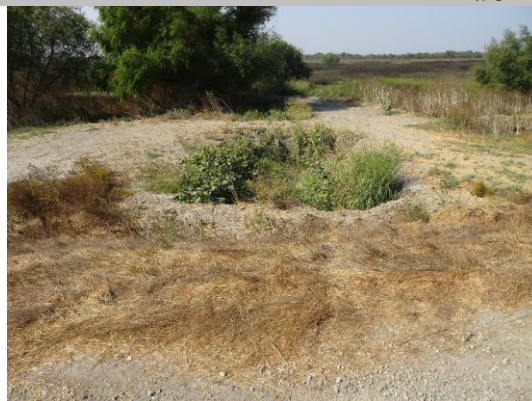
Photo 2 of 3 : UCIP\_FA\_2021\_64713\_90589.jpg

WS view: Pipe and flapgate not visible on WS toe due to vegetation

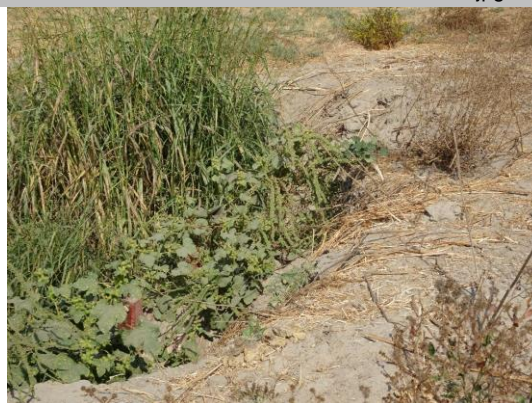
Photo 3 of 3 : UCIP\_FA\_2021\_64713\_92310.jpg

WS view: through the dense vegetation the pipe and red flap gate are visible.

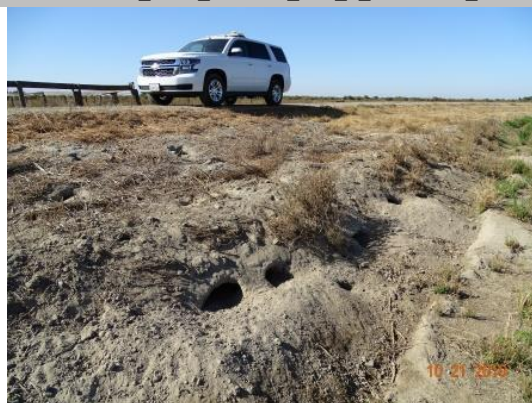
Photo 1 of 1 : FA\_2021\_NA0010\_118\_2\_20210830\_00001.jpg

LM Start	3.87	Rating **	U	Issue No.	2
LM End	3.90	Issue Type +	Ma	Location *	LS
Category	Earthen Levee			GPS Latitude/Longitude	
				Start	End
Item	Animal Control			37.311798 °	37.311341 °
				-120.927670 °	-120.927365 °
DWR ID	DWR_NA0010_01_s_2012_2				
Comment Code					
A1 : Exterminate rodents and backfill and compact or grout burrows.					
Inspector Comment					
Several rodent burrows are along this section of the levee.

View of rodent burrows in this section looking downstream. (Fall 2019)

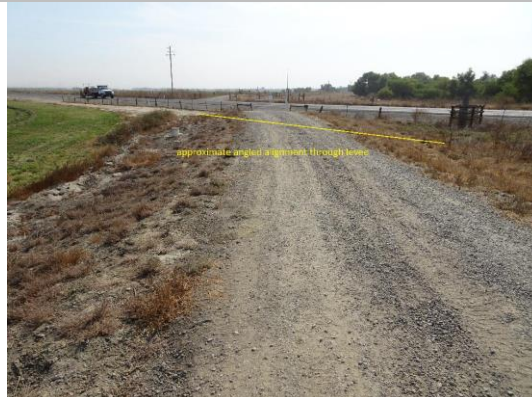
Photo 1 of 3 : UCIP\_FA\_2021\_64846\_90650.jpg

Comment Code					
Inspector Comment					
DS_ID:19576 FS_ID:64846 EP_NO: N/A Repair Type: Urgent EVAL Issue: Flood Risk Crossing Status: Found UCIP Comments: 10/06/2020 Record updated from Non-Urgent to Urgent. Heavy siltation through the length of the pipe was observed and recommend removal. Flap gate is missing on the WS toe. Recommend adding flap gate to prevent flooding from the WS to the LS. No permit was found authorizing this encroachment. CVFPB will need to review crossing to determine owner. DWR DMP internal inspection is pending and scheduled for 2021. Pipe goes through the levee at an angle. System description has been updated to include angled pipe information.(B. Singh - GEI, O. Magana - DWR UCIP)04/08/2014 Slide gate missing from WS. No closure device, but degrading of levee at Highway 140 is lower than pipe, so this does not appear to be a critical issue. Also dense vegetation limits the inspector's visibility to identify signs of pipe failure (leaks) along the slope. Recommend removing vegetation along pipe alignment to conduct proper inspection of structure and appurtenances. (W. Wylie - DWR UCIP) FIELD_STRUCT_DESC: 30-inch corrugated metal gravity drainage pipe through the levee at an angle, 3.5 feet below the crown. Flap gate on the waterside (WS) end. Brass cap No. 100 bench mark (BM) on the headwall on the landside (LS). [Additional Reference(s): DWR Levee Log, 2002 (HLM 3.95), listed as a 30-inch corrugated metal pipe (CMP). USACE San Joaquin O&M Manual, Unit 601 Part 1 (SJR601.1), 1967, Revised 25 May 2011, (HLM 3.95), listed as a 30-inch CMP]. FS Date: 10/6/2020

Overview of levee crown, looking US. Angled pipe alignment through levee crown approximated.

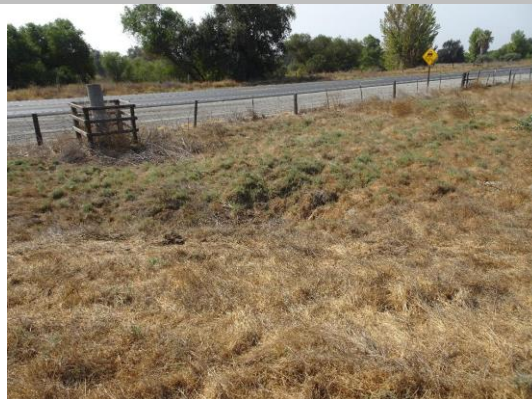
Photo 2 of 3 : UCIP\_FA\_2021\_64846\_90651.jpg

WS view: View toward WS toe. Pipe not visible.

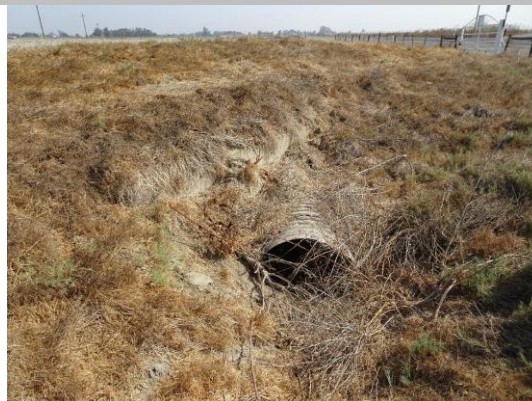
Photo 3 of 3 : UCIP\_FA\_2021\_64846\_90652.jpg

WS view: Heavy siltation at WS invert. Pipe flapgate missing at WS toe.

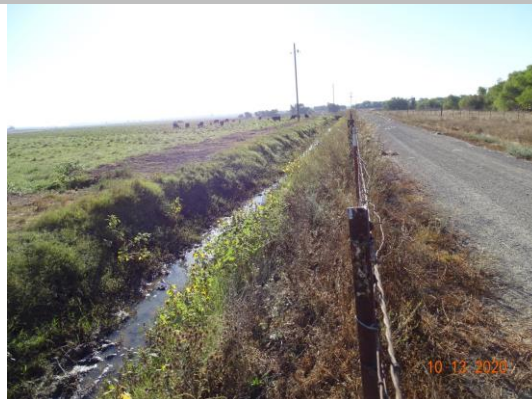
Photo 1 of 1 : FA\_2021\_NA0010\_118\_5\_20210830\_00002.jpg

LM Start	3.98	Rating **	U	Issue No.	5
LM End	4.05	Issue Type +	En	Location *	LS
Category	Earthen Levee			GPS Latitude/Longitude	
				Start	End
Item	Encroachments			37.310837 °	37.310003 °
				-120.926182 °	-120.925313 °
DWR ID	DWR_NA0010_01_s_2012_5				
Comment Code					
DT : Ditch					
Inspector Comment					
Irrigation ditch at landside toe.

Looking south at irrigation ditch at the landside toe. (Fall 2020)

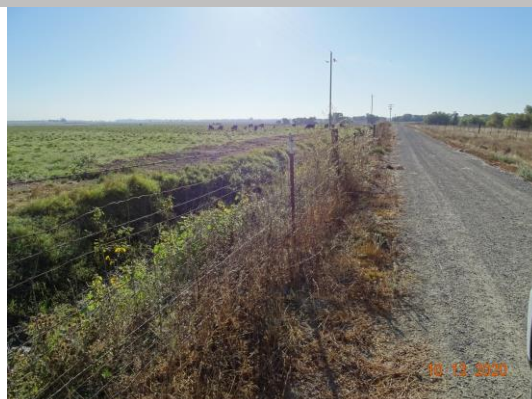
Photo 1 of 1 : FA\_2021\_NA0010\_118\_118\_20210830\_00020.jpg

LM Start	3.99	Rating **	M	Issue No.	118
LM End	4.25	Issue Type +	En	Location *	LS
Category	Earthen Levee			GPS Latitude/Longitude	
				Start	End
Item	Encroachments			37.310693 °	37.307895 °
				-120.926024 °	-120.922935 °
DWR ID	DWR_NA0010_01_f_2018_118				
Comment Code					
FE : Fence					
Inspector Comment					
Fence along landside toe.

View of fence on the landside shoulder and toe. (Fall 2020)

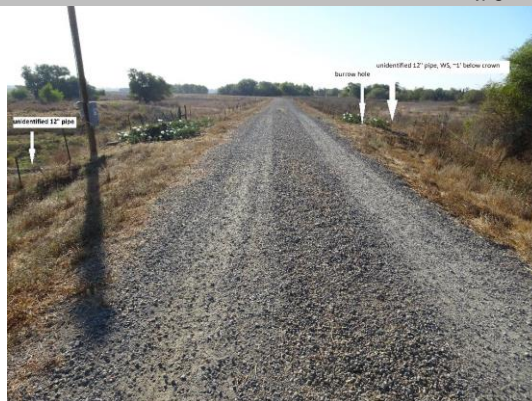
Photo 1 of 3 : UCIP\_FA\_2021\_64848\_90661.jpg

Comment Code						
Inspector Comment						
DS_ID:19607 FS_ID:64848 EP_NO: N/A Repair Type: Non-Urgent EVAL Issue: Limited Inspection/No UCIP Evaluation Crossing Status: Found UCIP Comments: 10/20/2020 Record remains Non-Urgent. Barbed wire prevented access to the pipe located on the LS toe. Unpermitted modifications were made to the structure. There appears to be multiple crossings at this location, two 12-inch pipes and 48-inch refurbished pipe. Recommend adding new DSID for the second 12-inch pipe found during field inspection. Portion of concrete headwall visible on the WS toe that corresponds to 48-inch pipe. Recommend contacting owner to determine status of structure and obtain as-builts. No permit was found authorizing these encroachments. CVFPB will need to review crossing to determine owner(s). (B. Singh - GEI, O. Magana - DWR UCIP)04/08/2014 Pipe appears sleeved with a 12-inch steel pipe with a slide gate at the LS toe. No identified authorization for changes to this crossing. Need to contact owner to obtain additional information about the modifications to crossing. (W. Wylie - DWR UCIP) FIELD_STRUCT_DESC: 48-inch corrugated metal gravity drainage pipe through the levee, 14 feet below the crown. Flap gate on the waterside (WS) end. Brass cap No. 90 bench mark (BM) on the headwall on the landside (LS). [Additional Reference(s): DWR Levee Log, 2002 (HLM 4.16), listed as a 48-inch pipe. USACE San Joaquin O&M Manual, Unit 601 Part 1 (SJR601.1), 1967, Revised 25 May 2011, (HLM 4.16), listed as a 48-inch corrugated metal pipe (CMP)]. FS Date: 10/20/2020

Overview of levee crown showing location of burrow hole and alignment of unauthorized 12" pipe

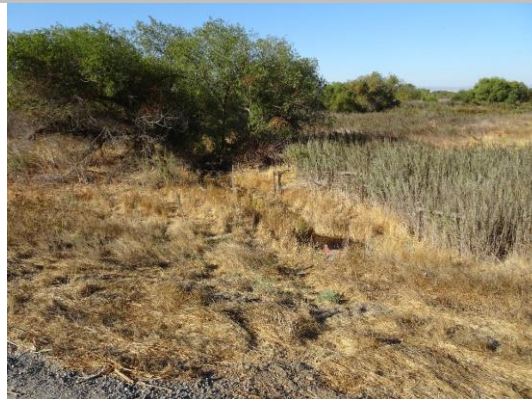
Photo 2 of 3 : UCIP\_FA\_2021\_64720\_90678.jpg

DS\_ID:19609  
FS\_ID:64720  
EP\_NO: N/A  
Repair Type: Urgent  
EVAL Issue: Pipe Integrity  
Crossing Status: Found  
UCIP Comments: 10/20/2020 Record has been updated from Non-Urgent to Urgent. DWR DMP has found integrity issues, LOF, between 5 and 6. Crossing will be monitored until funding becomes available to address. Evidence of the landslide visible on the LS slope from the levee crown. No permit was found authorizing this encroachment. CVFPB will need to review crossing to determine owner. (B. Singh - GEI, O. Magana - DWR UCIP)04/08/2014 Dense vegetation limits the inspector's visibility to identify signs of pipe failure (leaks) along the waterward side. Recommend removing vegetation along pipe alignment to conduct proper inspection of structure and appurtenances. (W. Wylie - DWR UCIP)  
FIELD\_STRUCT\_DESC: 24-inch corrugated metal gravity drainage pipe through the levee, 10 feet below the crown. Flap gate on the waterside (WS) end. Brass cap No. 90 bench mark (BM) on the headwall on the landside (LS). [Additional Reference(s): DWR Levee Log, 2002 (HLM 4.73), listed as a 24-inch corrugated metal pipe (CMP). USACE San Joaquin O&M Manual, Unit 601 Part 1 (SJR601.1), 1967, Revised 25 May 2011, (HLM 4.72), listed as a 24-inch CMP].

WS view: Pipe and flapgate visible at WS toe

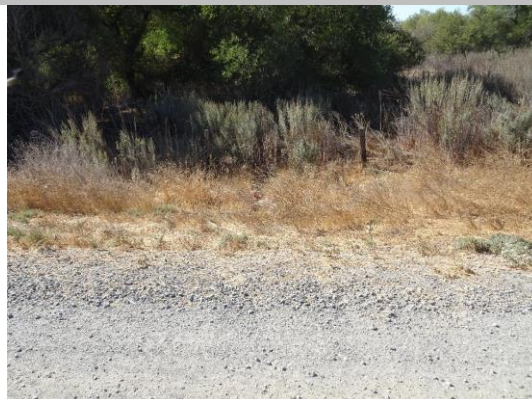
Photo 2 of 3 : UCIP\_FA\_2021\_64851\_90684.jpg

Comment Code					
Inspector Comment					
DS_ID:19610 FS_ID:64851 EP_NO: N/A Repair Type: Non-Urgent EVAL Issue: Limited Inspection/No UCIP Evaluation Crossing Status: Found UCIP Comments: 10/20/2020 Record remains Non-Urgent. Unable to locate inlet on the LS toe. Ditch runs along the LS toe. Ditch was running full and no signs of pipe inlet were visible. This pipe appears to be non-functional--only WS pipe outlet found. No permit was found authorizing this encroachment. CVFPB will need to review crossing to determine owner. DWR DMP internal inspection is pending and scheduled for 2021. (B. Singh - GEI, O. Magana - DWR UCIP)04/08/2014 Non-functional -- sediment buildup against flapgate and inlet buried at landward side. (W. Wylie - DWR UCIP) FIELD_STRUCT_DESC: 24-inch corrugated metal gravity drainage pipe through the levee, 8 feet below the crown. Flap gate on the waterside (WS) end. Brass cap No. 90 bench mark (BM) on the headwall on the landside (LS). Ditch located along the LS toe. [Additional Reference(s): DWR Levee Log, 2002 (HLM 5.06), listed as a 24-inch corrugated metal pipe (CMP). USACE San Joaquin O&M Manual, Unit 601 Part 1 (SJR601.1), 1967, Revised 25 May 2011, (HLM 5.05), listed as a 24-inch CMP]. FS Date: 10/20/2020

WS view: Pipe and flapgate visible on WS toe
