## Flood Control Project Maintenance Levee Inspections

### Fall 2021 Levee Maintenance Deficiency Summary Report

#### San Joaquin River Basin

NA0010 Lower San Joaquin Levee District	Overall LMA Rating	Total LMA Miles							
	U	191.27							
Rated Item	Maintenance Deficiency				Enforcement		Design & System Obsolescence		
	M Miles	U Miles	M + 4U Miles	Threshold %	M Miles	U Miles	M Miles	U Miles	
<i>Earthen Levee</i>									
Vegetation	47.00	9.57	85.28	44.59%					
Trim / Thin Trees	0.10		0.10	0.05%					
Encroachments	0.23	0.02	0.31	0.16%	9.29	0.59			
Animal Control	7.67	2.19	16.43	8.59%					
Slope Stability	0.05	0.01	0.09	0.05%					
Erosion / Bank Caving	0.13	0.81	3.37	1.76%					
Crown Surface / Depressions / Rutting	0.01		0.01	0.01%					
Repair Gates	0.02	0.02	0.10	0.05%					
<i>Rivers, Channels &amp; Designated Floodways</i>									
Encroachments					0.01	0.01			
<i>Supplemental</i>									
DWR Erosion Survey	0.12	0.17	0.80	0.42%					
DWR UCIP Field Study					1.29	0.05			
DWR UCIP LMA Responsibility									
<i>LMA Totals:</i>	55.33	12.79	106.49	55.67%	10.59	0.65	0.00	0.00

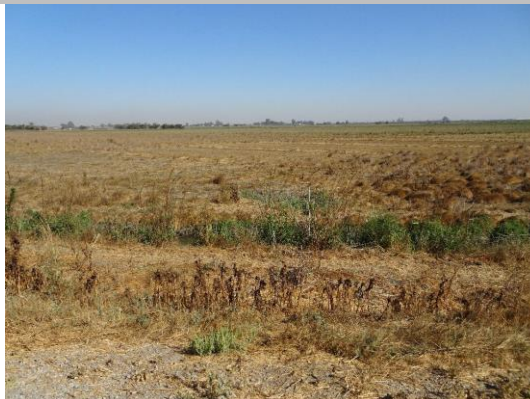
Photo 3 of 3 : UCIP\_FA\_2021\_64851\_90683.jpg

Comment Code					
Inspector Comment					
DS_ID:19610 FS_ID:64851 EP_NO: N/A Repair Type: Non-Urgent EVAL Issue: Limited Inspection/No UCIP Evaluation Crossing Status: Found UCIP Comments: 10/20/2020 Record remains Non-Urgent. Unable to locate inlet on the LS toe. Ditch runs along the LS toe. Ditch was running full and no signs of pipe inlet were visible. This pipe appears to be non-functional--only WS pipe outlet found. No permit was found authorizing this encroachment. CVFPB will need to review crossing to determine owner. DWR DMP internal inspection is pending and scheduled for 2021. (B. Singh - GEI, O. Magana - DWR UCIP)04/08/2014 Non-functional -- sediment buildup against flapgate and inlet buried at landward side. (W. Wylie - DWR UCIP) FIELD_STRUCT_DESC: 24-inch corrugated metal gravity drainage pipe through the levee, 8 feet below the crown. Flap gate on the waterside (WS) end. Brass cap No. 90 bench mark (BM) on the headwall on the landside (LS). Ditch located along the LS toe. [Additional Reference(s): DWR Levee Log, 2002 (HLM 5.06), listed as a 24-inch corrugated metal pipe (CMP). USACE San Joaquin O&M Manual, Unit 601 Part 1 (SJR601.1), 1967, Revised 25 May 2011, (HLM 5.05), listed as a 24-inch CMP]. FS Date: 10/20/2020

LS view: Pipe and headwall not visible at LS toe from levee crown

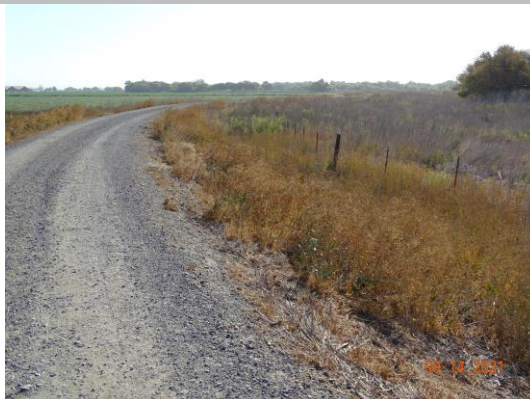
Photo 1 of 1 : FA\_2021\_NA0010\_118\_125\_20210927\_00293.jpg

LM Start	5.72	Rating **	M	Issue No.	125
LM End	6.50	Issue Type +	Ma	Location *	WS
Category	Earthen Levee			GPS Latitude/Longitude	
				Start	End
Item	Vegetation			37.304074 °	37.304098 °
				-120.907149 °	-120.893902 °
DWR ID	DWR_NA0010_01_f_2021_125				
Comment Code					
V1 : Control annual grass and weeds on the levee slopes and easements.					
Inspector Comment

Looking upstream along the waterside slope. (Fall 2021)

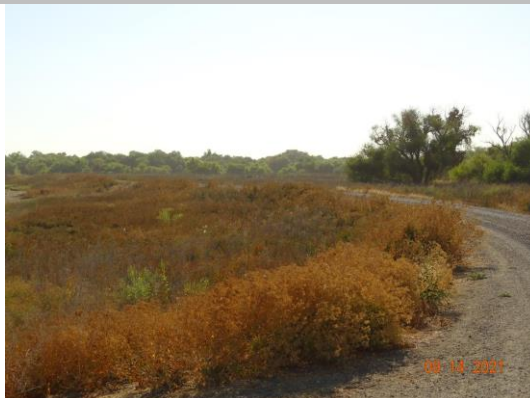
Photo 1 of 1 : FA\_2021\_NA0010\_118\_126\_20210927\_00294.jpg

LM Start	5.72	Rating **	M	Issue No.	126
LM End	6.88	Issue Type +	Ma	Location *	LS
Category	Earthen Levee			GPS Latitude/Longitude	
				Start	End
Item	Vegetation			37.304080 °	37.301996 °
				-120.907138 °	-120.887665 °
DWR ID	DWR_NA0010_01_f_2021_126				
Comment Code					
V1 : Control annual grass and weeds on the levee slopes and easements.					
Inspector Comment

View of the landside slope looking upstream. (Fall 2021)

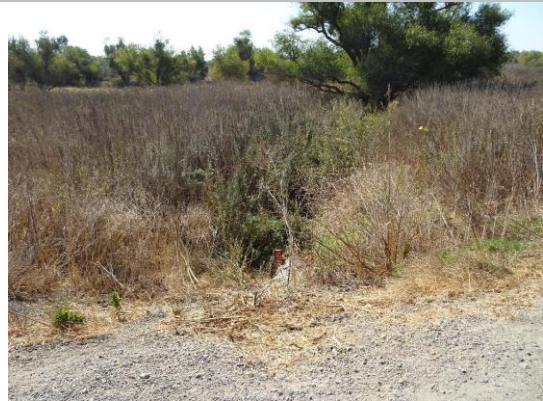
Photo 2 of 3 : UCIP\_FA\_2021\_64852\_90691.jpg

WS view: Pipe and flapgate visible at WS toe

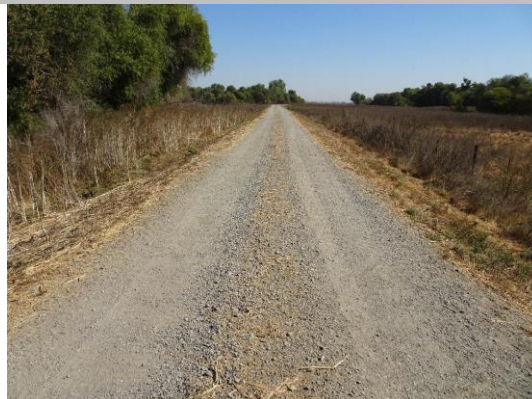
Photo 1 of 3 : UCIP\_FA\_2021\_64723\_90696.jpg

Comment Code					
Inspector Comment					
DS_ID:19612 FS_ID:64723 EP_NO: N/A Repair Type: Non-Urgent EVAL Issue: Levee Damage or Threat for Levee Damage Crossing Status: Found UCIP Comments: 10/20/2020 Record remains Non-Urgent. Scour is still present on both sides of the concrete LS headwall. Dense vegetation prevented updates on the scour progression along the LS slope. Recommend re-inspecting pipe when vegetation is removed. Unable to access to WS outlet due to wired fence. No permit was found authorizing this encroachment. CVFPB will need to review crossing to determine owner. DWR DMP internal inspection is pending and scheduled for 2021. (B. Singh - GEI, O. Magana - DWR UCIP)04/08/2014 Dense vegetation limits the inspector's visibility to identify signs of pipe failure (leaks) along waterward and landward slopes. Recommend removing vegetation along pipe alignment to conduct proper inspection of structure and appurtenances. Pipe completely blocked by soil on LS toe due to animal activity. Slide gate blocked open. (W. Wylie - DWR UCIP) FIELD_STRUCT_DESC: 48-inch corrugated metal gravity drainage through the levee, 13.1 feet below the crown. Walkway to slide gate at the concrete headwall on the landside (LS) toe. Flap gate at the concrete headwall on the waterside (WS) toe. Brass cap No. 90 bench mark (BM) on the headwall on the LS. Pipe crosses the levee at an angle. [Additional Reference(s): DWR Levee Log, 2002 (HLM 6.13), listed as a 48-inch corrugated metal pipe (CMP). USACE San Joaquin O&M Manual, Unit 601 Part 1 (SJR601.1), 1967, Revised 25 May 2011, (HLM 6.13), listed as a 48-inch CMP]. FS Date: 10/20/2020

Overview of levee crown, looking US

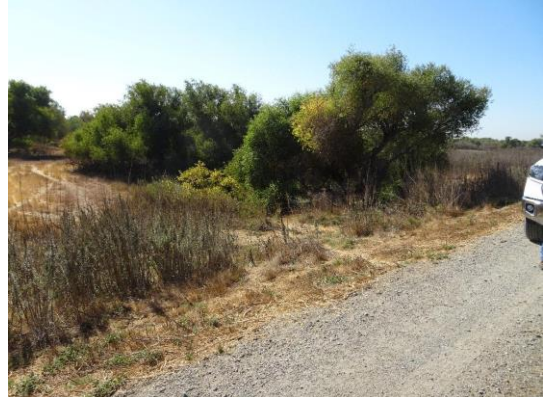
Photo 2 of 3 : UCIP\_FA\_2021\_64723\_90698.jpg

WS view: View of WS toe from levee crown. Headwall, pipe, and flapgate not visible from levee crown.

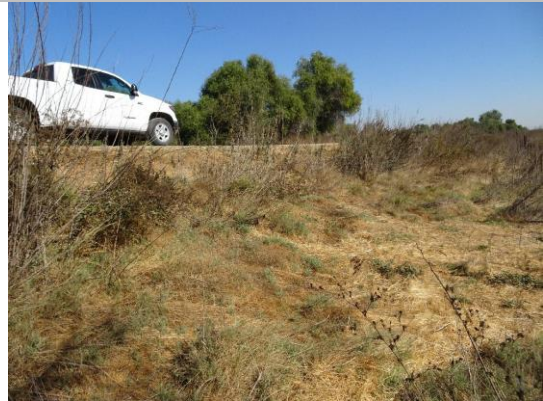
Photo 3 of 3 : UCIP\_FA\_2021\_64723\_90695.jpg

WS view: Levee slope from WS toe

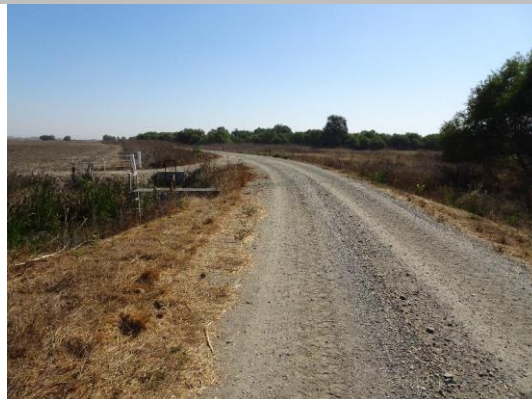
Photo 1 of 3 : UCIP\_FA\_2021\_64729\_90702.jpg

DS\_ID:19613  
FS\_ID:64729  
EP\_NO: N/A  
Repair Type: Non-Urgent  
EVAL Issue: Limited Inspection/No UCIP Evaluation  
Crossing Status: Found  
UCIP Comments: 10/20/2020 Record remains Non-Urgent. Dense vegetation on WS toe, recommend removal for proper inspection. Minor surface erosion visible on the LS toe near the standpipe. No permit was found authorizing this encroachment. CVFPB will need to review crossing to determine owner. DWR DMP internal inspection is pending and scheduled for 2021. (B. Singh - GEI, O. Magana - DWR UCIP)04/08/2014 Dense vegetation limits the inspector's visibility to identify signs of pipe failure (leaks) along the slope. Recommend removing vegetation along pipe alignment to conduct proper inspection of structure and appurtenances. (W. Wylie - DWR UCIP)  
FIELD\_STRUCT\_DESC: 24-inch corrugated metal gravity drainage pipe through the levee, 9.5 feet below the crown. Flap gate on the waterside (WS) end. Slide gate on the landside (LS) end next to a 48-inch concrete riser with walkway over the top. Brass cap No. 90 bench mark (BM) on the headwall on the LS. [Additional Reference(s): DWR Levee Log, 2002 (HLM 6.44), listed as a 24-inch corrugated metal pipe (CMP). USACE San Joaquin O&M Manual, Unit 601 Part 1 (SJR601.1), 1967, Revised 25 May 2011, (HLM 6.40), listed as a 24-inch CMP].

Overview of levee crown, looking upstream

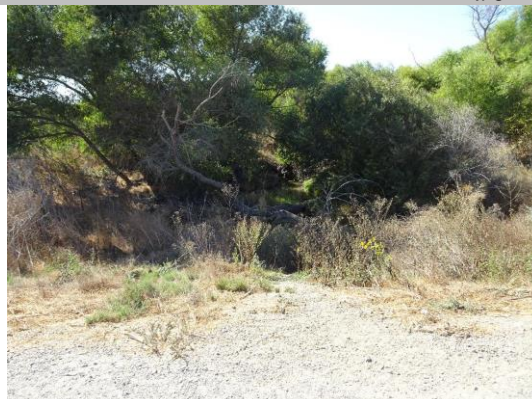
Photo 2 of 3 : UCIP\_FA\_2021\_64729\_90705.jpg

WS view: Headwall not visible on WS toe due to dense vegetation

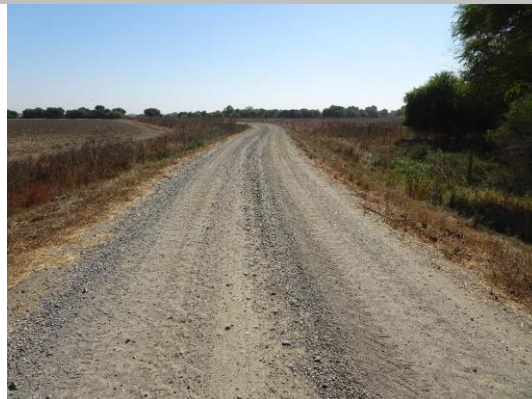
Photo 1 of 3 : UCIP\_FA\_2021\_64730\_90712.jpg

Comment Code						
Inspector Comment						
DS_ID:19614 FS_ID:64730 EP_NO: N/A Repair Type: Non-Urgent EVAL Issue: Limited Inspection/No UCIP Evaluation Crossing Status: Found UCIP Comments: 10/20/2020 Record remains Non-Urgent. Dense vegetation inhibits inspection of the pipe on the LS toe, and both slopes. No permit was found authorizing this encroachment. CVFPB will need to review crossing to determine owner. DWR DMP internal inspection is pending and scheduled for 2021. (B. Singh - GEI, O. Magana - DWR UCIP)7/19/2016 Same as previous inspection. Outlet and inlet are under water. (O. Magana - DWR UCIP)4/08/2014 Flapgate blocked by sedimentation at WS toe. Dense vegetation limits the inspector's visibility to identify signs of pipe failure (leaks) along the slope. Recommend removing vegetation along pipe alignment to conduct proper inspection of structure and appurtenances. Also recommend clearing vegetation from both waterward and landward toe. (W. Wylie - DWR UCIP) FIELD_STRUCT_DESC: 24-inch corrugated metal gravity drainage pipe through the levee, 9.8 feet below the crown. Wooden fence around a 4-foot by 4-foot drop inlet on the landside (LS) toe. Flap gate on the waterside (WS) end. Brass cap No. 90 bench mark (BM) on the headwall on the LS. [Additional Reference(s): DWR Levee Log, 2002 (HLM 6.65), listed as a 24-inch corrugated metal pipe (CMP). USACE San Joaquin O&M Manual, Unit 601 Part 1 (SJR601.1), 1967, Revised 25 May 2011, (HLM 6.64), listed as a 24-inch CMP]. FS Date: 10/20/2020

Overview of levee crown, looking US

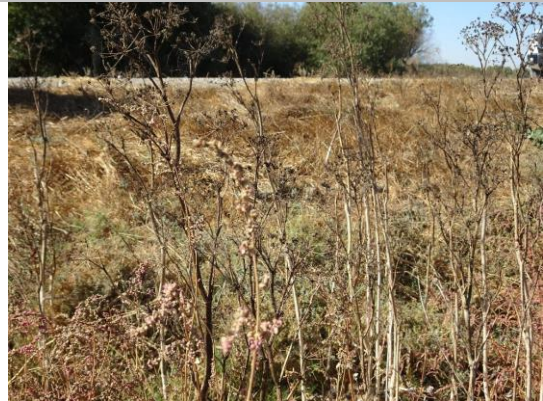
Photo 3 of 3 : UCIP\_FA\_2021\_64730\_90707.jpg

LS view: LS slope from LS toe

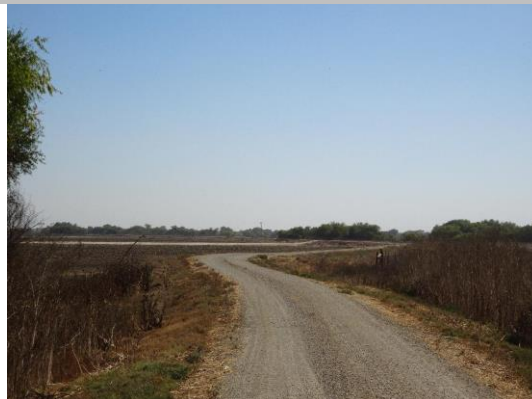
Photo 1 of 3 : UCIP\_FA\_2021\_64853\_90726.jpg

Comment Code					
Inspector Comment					
DS_ID:19615 FS_ID:64853 EP_NO: N/A Repair Type: Urgent EVAL Issue: Pipe Integrity Crossing Status: Found UCIP Comments: 10/20/2020 Record has been updated from Non-Urgent to Urgent. Heavy corrosion present with visible holes found at the WS outlet near flap gate. Surface erosion present on the LS slope just upstream of slide gate. Evidence of surface erosion on the WS slope (vertical slope) was present approximately 15 feet downstream of the pipe. Plastic sheeting has been placed to prevent further erosion by LMA (assumed). Recommend notifying DWR Levee Inspector to monitor progress of surface erosion on the WS. No permit was found authorizing this encroachment. CVFPB will need to review crossing to determine owner. DWR DMP internal inspection is pending and scheduled for 2021. (B. Singh - GEI, O. Magana - DWR UCIP)07/19/2016 Potential LS slope damage--difficult to determine due to dense vegetation. Limited access on WS toe due to wire fence. (O. Magana - DWR UCIP)04/08/2014 Slide gate blocked by debris at LS toe. Flapgate won't close because of debris. Dense vegetation limits the inspector's visibility to identify signs of pipe failure (leaks) along the slope. Recommend removing vegetation along pipe alignment to conduct proper inspection of structure and appurtenances. (W. Wylie - DWR UCIP) FIELD_STRUCT_DESC: 36-inch corrugated metal gravity drainage pipe through the levee, 10.3 feet below the crown. Slide gate on the landside (LS) toe. Flap gate on the waterside (WS) end. Brass cap No. 90 bench mark (BM) on the headwall on the LS. [Additional Reference(s): DWR Levee Log, 2002 (HLM 6.90), listed as a 36-inch corrugated metal pipe (CMP). USACE San Joaquin O&M Manual, Unit 601 Part 1 (SJR601.1), 1967, Revised 25 May 2011, (HLM 6.90), listed as a 36-inch CMP]. FS Date: 10/20/2020

Overview of levee crown, looking US

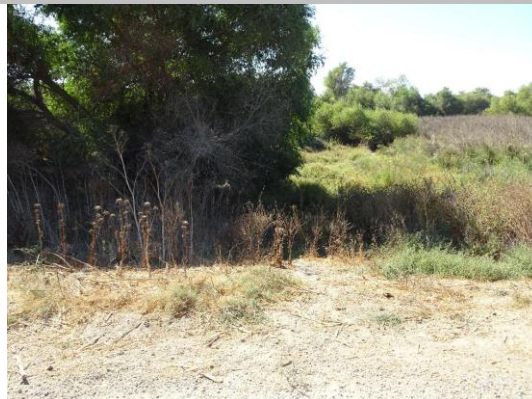
Photo 2 of 3 : UCIP\_FA\_2021\_64853\_92389.jpg

WS view: overview of WS.

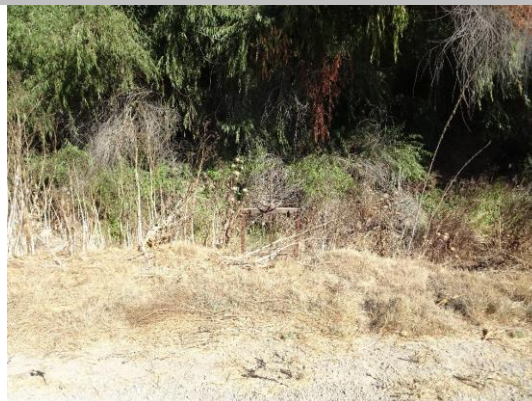
Photo 3 of 3 : UCIP\_FA\_2021\_64853\_90727.jpg

LS view: Pipe slidegate visible at LS toe.

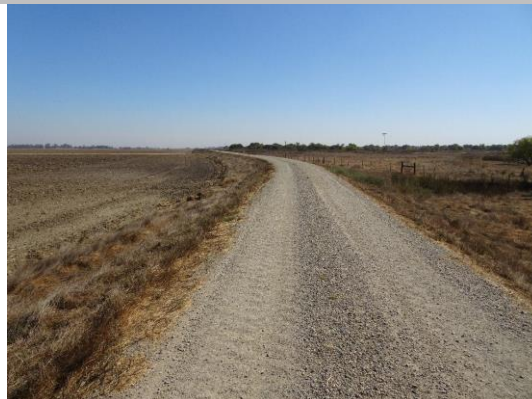
Photo 1 of 3 : UCIP\_FA\_2021\_64733\_90715.jpg

DS\_ID:19616  
FS\_ID:64733  
EP\_NO: N/A  
Repair Type: Urgent  
EVAL Issue: Pipe Integrity  
Crossing Status: Found  
UCIP Comments: 10/20/2020 Record remains Urgent. DWR DMP has found integrity issues, LOF between 5 and 6. Pipe deeply corroded. Crossing will be monitored until funding becomes available to address. No permit was found authorizing this encroachment. CVFPB will need to review crossing to determine owner. (B. Singh - GEI, O. Magana - DWR UCIP)11/01/2018 Pipe continues to corrode through. Voids (undermining) along pipe invert are visible from the LS. Potential undermining caused by erosion under concrete apron on the WS. Crossing remains Urgent due to the pipe failure. (O. Magana - DWR UCIP)04/08/2014 Pipe failing and corroded through at LS toe. Need to contact owner to determine status of crossing. Also dense vegetation limits the inspector's visibility to identify signs of pipe failure (leaks) along the landward slope. Recommend removing vegetation along pipe alignment to conduct proper inspection of structure. (W. Wylie - DWR UCIP)

Overview of levee crown, looking US

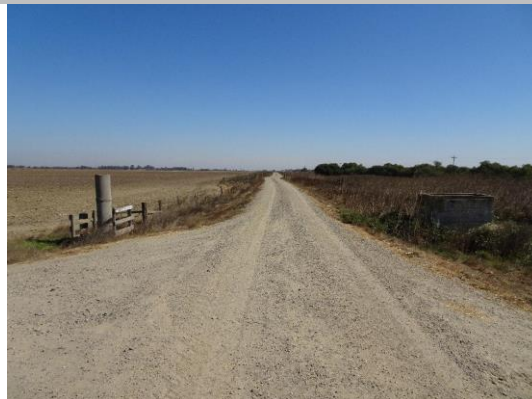
Photo 1 of 3 : UCIP\_FA\_2021\_64854\_90731.jpg

Comment Code						
Inspector Comment						
DS_ID:19617 FS_ID:64854 EP_NO: 4425 Repair Type: Non-Urgent EVAL Issue: Limited Inspection/No UCIP Evaluation Crossing Status: Found UCIP Comments: 10/20/2020 Record remains Non-Urgent. Additional structures (standpipes) located about 700 feet from levee crown. Due to safety concerns (lone worker), unable to access additional appurtenances located about 700 feet out from WS toe. Recommend having next UCIP inspector take close up photos of the structure located on the WS (riverbank). Recommend contacting owner to determine alignment of pipe through the levee and current status of pipe. The close-up photo of the structures near the riverbank show multiple concrete risers and control panel connected to power. Need to confirm current status of pipe. (B. Singh - GEI, O. Magana - DWR UCIP)04/08/2014 Recommend contacting owner to determine status of crossing. No pump was found on waterward side (riverbank). If crossing is no longer used need to coordinate with CVFPB for proper abandonment. (W. Wylie - DWR UCIP) FIELD_STRUCT_DESC: 24-inch concrete encased steel irrigation discharge pipe through the levee, 13.6 feet below the crown. Pipe encased in 6-inches of concrete through the levee. 5-foot by 7-foot concrete distribution box on the waterside (WS). 20-inch concrete standpipe at the landside (LS) toe. Pump on the riverbank, accessible by walkway platform. Concrete cutoff walls around pipe in line with the levee shoulders. Pipe extends to 36-inch concrete pipes on both sides of the levee. (Plans to install an irrigation pipeline through the levee authorized under Permit No. 4425, 1964 - James J. Stevinson, a Corporation). [Additional Reference(s): DWR Levee Log, 2002 (HLM 7.33), listed as a 24-inch pipe]. FS Date: 10/20/2020

Overview of levee, looking US

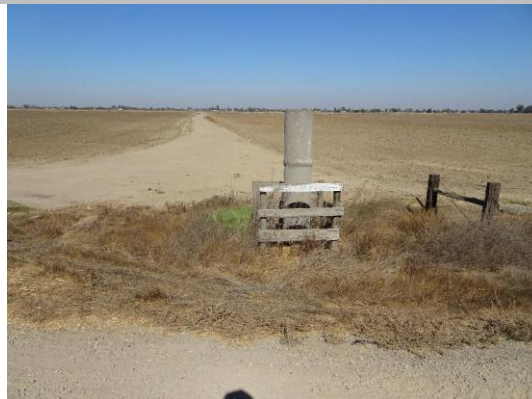
Photo 2 of 3 : UCIP\_FA\_2021\_64854\_90732.jpg

LS view: Concrete standpipe near LS toe

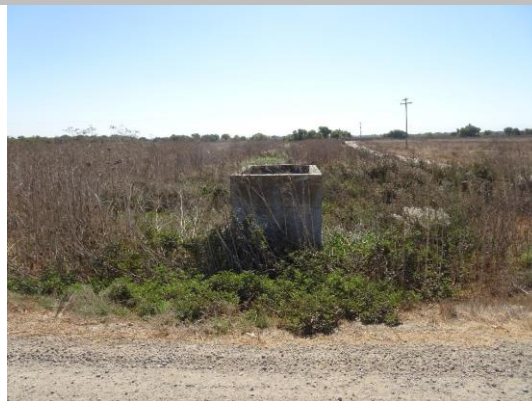
Photo 3 of 3 : UCIP\_FA\_2021\_64854\_90733.jpg

WS view: Concrete box riser at WS toe.

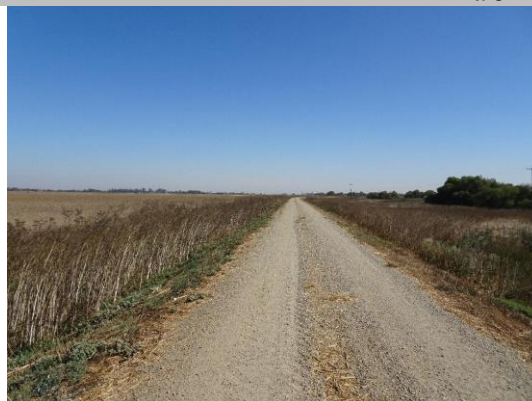
Photo 1 of 3 : UCIP\_FA\_2021\_64855\_90738.jpg

Comment Code						
Inspector Comment						
DS_ID:19618 FS_ID:64855 EP_NO: N/A Repair Type: Urgent EVAL Issue: Pipe Integrity Crossing Status: Found UCIP Comments: 10/20/2020 Record has been updated from Non-Urgent to Urgent. DWR DMP has found integrity issues, LOF between 5 and 6. Crossing will be monitored until funding becomes available to address. Topography of WS toe has changed over time with sediment build-up preventing proper drainage. At the pipe outlet there is a gradual ground elevation change that causes the water to pond against the flap gate. No permit was found authorizing this encroachment. CVFPB will need to review crossing to determine owner. (B. Singh - GEI, O. Magana - DWR UCIP)04/08/2014 Dense vegetation limits the inspector's visibility to identify signs of pipe failure (leaks) along the slope. Recommend removing vegetation along pipe alignment to conduct proper inspection of structure and appurtenances. (W. Wylie - DWR UCIP) FIELD_STRUCT_DESC: 24-inch corrugated metal gravity drainage pipe through the levee, 8 feet below the crown. Flap gate on the waterside (WS) end. Brass cap No. 80 bench mark (BM) on the headwall on the landside (LS). [Additional Reference(s): DWR Levee Log, 2002 (HLM 7.46), listed as a corrugated metal pipe (CMP). USACE San Joaquin O&M Manual, Unit 601 Part 1 (SJR601.1), 1967, Revised 25 May 2011, (HLM 7.46), listed as a 24-inch CMP]. FS Date: 10/20/2020

Overview of levee crown, looking US

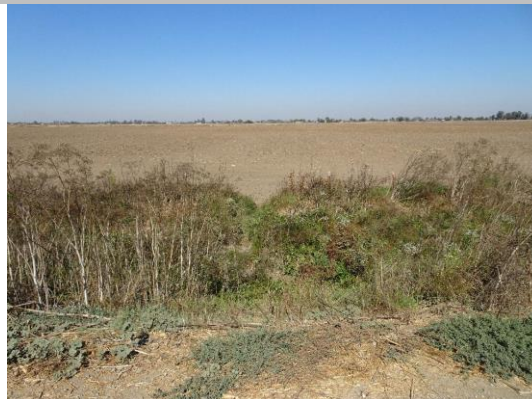
Photo 2 of 3 : UCIP\_FA\_2021\_64855\_90739.jpg

LS view: Headwall not visible at LS toe from levee crown due to vegetation

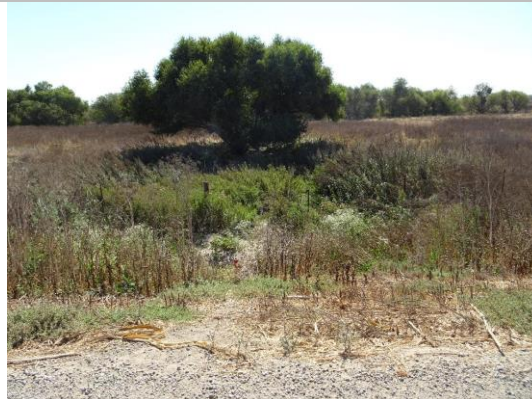
Photo 3 of 3 : UCIP\_FA\_2021\_64855\_90740.jpg

WS view: Flapgate visible at WS toe

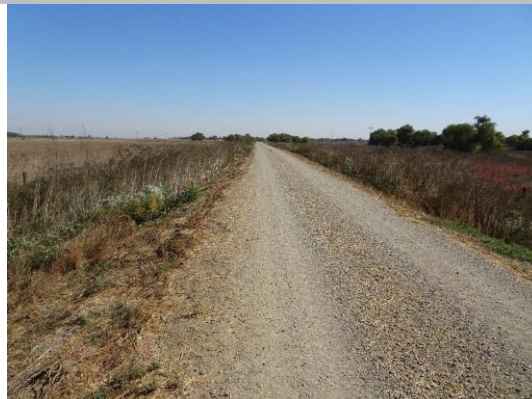
Photo 1 of 3 : UCIP\_FA\_2021\_64736\_90744.jpg

Comment Code					
Inspector Comment					
DS_ID:19619 FS_ID:64736 EP_NO: N/A Repair Type: Urgent EVAL Issue: Pipe Integrity Crossing Status: Found UCIP Comments: 10/20/2020 Record has been updated from Non-Urgent to Urgent. Sloughing observed on the LS slope above headwall. DWR DMP has found integrity issues, LOF between 5 and 6. Crossing will be monitored until funding becomes available to address. No permit was found authorizing this encroachment. CVFPB will need to review crossing to determine owner. (B. Singh - GEI, O. Magana - DWR UCIP)04/08/2014 Dense vegetation limits the inspector's visibility to identify signs of pipe failure (leaks) along the slope. Recommend removing vegetation along pipe alignment to conduct proper inspection of structure. (W. Wylie - DWR UCIP) FIELD_STRUCT_DESC: 24-inch corrugated metal gravity drainage pipe through the levee, 10 feet below the crown. Flap gate on the waterside (WS) end. Brass cap No. 80 bench mark (BM) on the headwall on the landside (LS). [Additional Reference(s): DWR Levee Log, 2002 (HLM 7.70), listed as a 24-inch corrugated metal pipe (CMP). USACE San Joaquin O&M Manual, Unit 601 Part 1 (SJR601.1), 1967, Revised 25 May 2011, (HLM 7.69), listed as a 24-inch CMP]. FS Date: 10/20/2020

Overview of levee crown, looking US

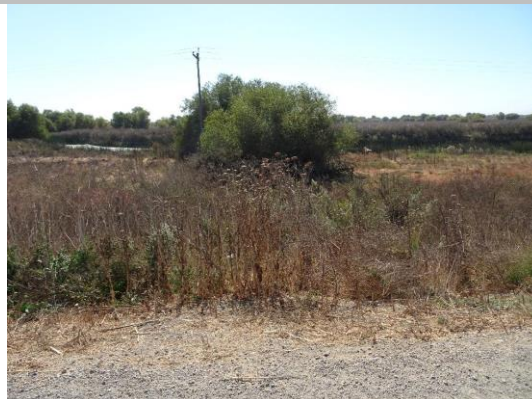
Photo 2 of 3 : UCIP\_FA\_2021\_64736\_90746.jpg

WS view: View toward WS toe

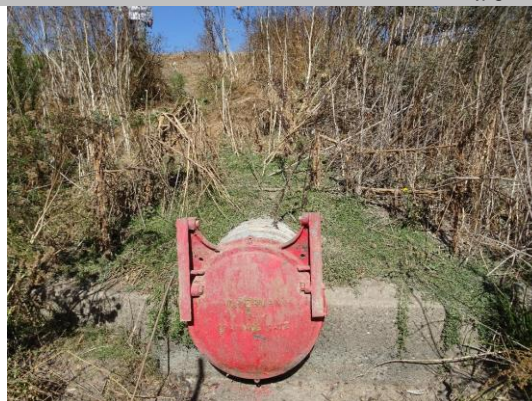
Photo 3 of 3 : UCIP\_FA\_2021\_64736\_90743.jpg

WS view: Pipe, headwall, and flapgate on WS toe

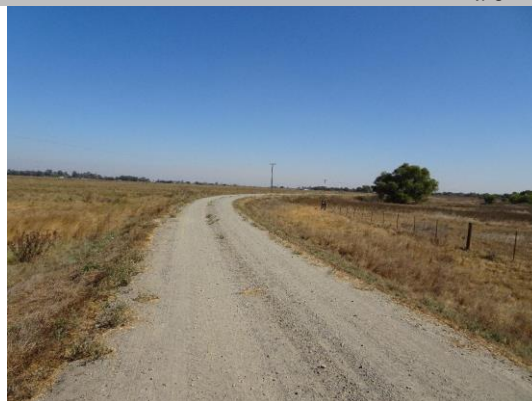
Photo 1 of 3 : UCIP\_FA\_2021\_64856\_92400.jpg

DS\_ID:19620  
FS\_ID:64856  
EP\_NO: N/A  
Repair Type: Non-Urgent  
EVAL Issue: Pipe Damage  
Crossing Status: Found  
UCIP Comments: 10/20/2020 Record remains Non-Urgent. DWR DMP has found integrity issues, LOF between 4 and 5. Corrosion in pipe visible on the LS toe. Crossing will be monitored until funding becomes available for rehabilitation. No permit was found authorizing this encroachment. CVFPB will need to review crossing to determine owner. (B. Singh - GEI, O. Magana - DWR UCIP)04/09/2014 Dense vegetation limits the inspector's visibility to identify signs of pipe failure (leaks) along the slope. Recommend removing vegetation along pipe alignment to conduct proper inspection of structure. (W. Wylie - DWR UCIP)  
FIELD\_STRUCT\_DESC: 24-inch corrugated metal gravity drainage pipe through the levee, 8 feet below the crown. Flap gate on the waterside (WS) end. Brass cap No. 80 bench mark (BM) on the headwall on the landside (LS). [Additional Reference(s): DWR Levee Log, 2002 (HLM 8.09), listed as a 24-inch corrugated metal pipe (CMP). USACE San Joaquin O&M Manual, Unit 601 Part 1 (SJR601.1), 1967, Revised 25 May 2011, (HLM 8.07), listed as a 24-inch CMP].

Overview of levee crown, looking U/S from several hundred feet away from crossing.

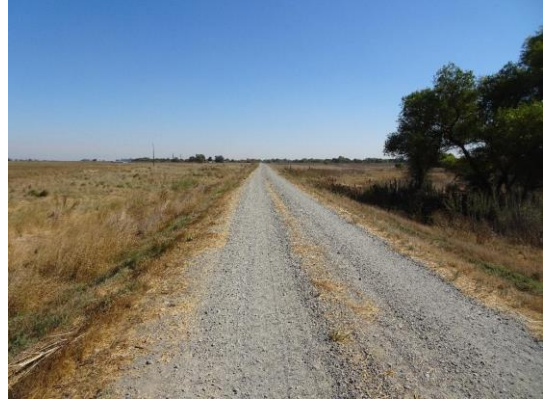
Photo 2 of 3 : UCIP\_FA\_2021\_64856\_90750.jpg

Overview of levee crown, looking US

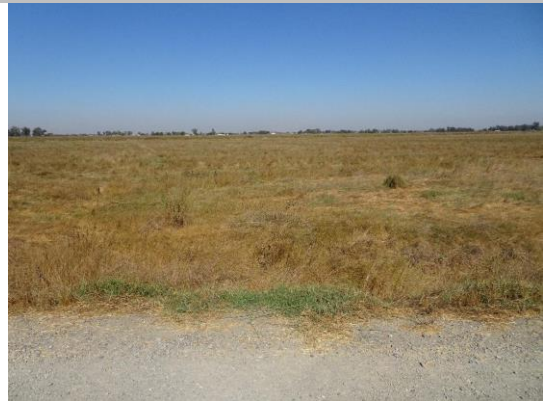
Photo 3 of 3 : UCIP\_FA\_2021\_64856\_90751.jpg

LS toe from levee crown

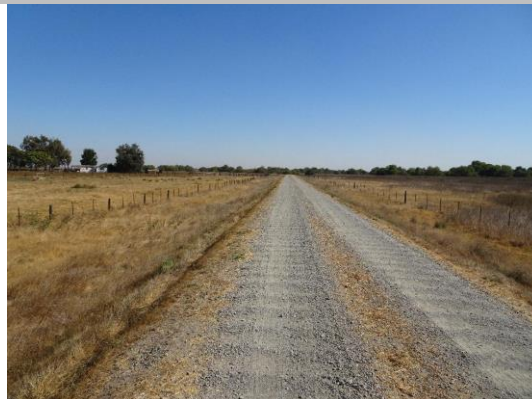
Photo 1 of 3 : UCIP\_FA\_2021\_64857\_90757.jpg

Comment Code					
Inspector Comment					
DS_ID:19621 FS_ID:64857 EP_NO: N/A Repair Type: Non-Urgent EVAL Issue: Pipe Damage Crossing Status: Found UCIP Comments: 10/20/2020 Record remains Non-Urgent. DWR DMP has found integrity issues, LOF between 4 and 5. Crossing will be monitored until funding becomes available for rehabilitation. No permit was found authorizing this encroachment. CVFPB will need to review crossing to determine owner. (B. Singh - GEI, O. Magana - DWR UCIP)04/09/2014 Dense vegetation limits the inspector's visibility to identify signs of pipe failure (leaks) along the slope. Recommend removing vegetation along pipe alignment to conduct proper inspection of structure. Sediment buildup at landward toe. (W. Wylie - DWR UCIP) FIELD_STRUCT_DESC: 24-inch corrugated metal gravity drainage pipe through the levee, 9.5 feet below the crown. Flap gate on the waterside (WS) end. Brass cap No. 80 bench mark (BM) on the headwall on the landside (LS). [Additional Reference(s): DWR Levee Log, 2002 (HLM 8.43), listed as a 24-inch corrugated metal pipe (CMP). USACE San Joaquin O&M Manual, Unit 601 Part 1 (SJR601.1), 1967, Revised 25 May 2011, (HLM 8.41), listed as a 24-inch CMP]. FS Date: 10/20/2020

Overview of levee crown, looking US

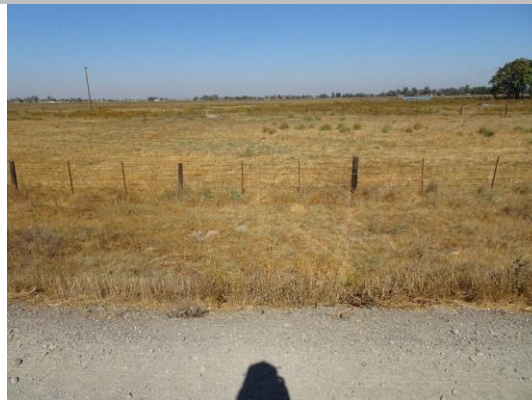
Photo 2 of 3 : UCIP\_FA\_2021\_64857\_90758.jpg

LS view: View of LS toe from levee crown

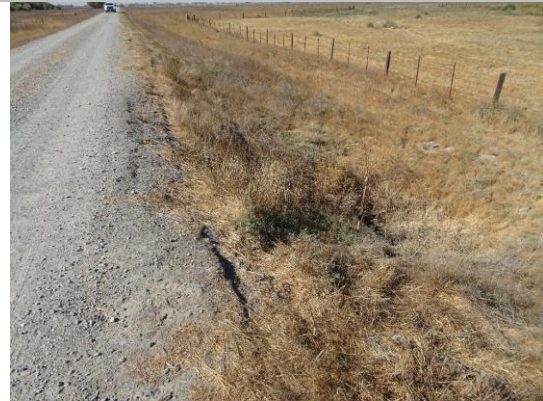
Photo 3 of 3 : UCIP\_FA\_2021\_64857\_92416.jpg

LS view: overview of LS slope profile.

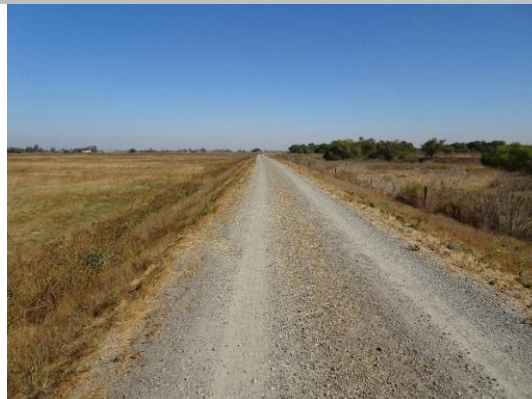
Photo 1 of 3 : UCIP\_FA\_2021\_64743\_90770.jpg

Comment Code						
Inspector Comment						
DS_ID:19622 FS_ID:64743 EP_NO: N/A Repair Type: Non-Urgent EVAL Issue: Unauthorized Encroachment, installed decades prior Crossing Status: Found UCIP Comments: 10/20/2020 Record has been updated from No Action Needed to Non-Urgent. Large burrow hole observed approximately 100 feet downstream of the pipe, on LS shoulder of the levee crown. No permit was found authorizing this encroachment. CVFPB will need to review crossing to determine owner. DWR DMP has not found internal issues, LOF between 1 and 2. Recommend inspection in 5 years. (B. Singh - GEI, O. Magana - DWR UCIP) FIELD_STRUCT_DESC: 24-inch corrugated metal gravity drainage pipe through the levee, 9 feet below the crown. Flap gate on the waterside (WS) end. Brass cap No. 80 bench mark (BM) on the headwall on the landside (LS). [Additional Reference(s): DWR Levee Log, 2002 (HLM 8.62), listed as a 24-inch corrugated metal pipe (CMP). USACE San Joaquin O&M Manual, Unit 601 Part 1 (SJR601.1), 1967, Revised 25 May 2011, (HLM 8.61), listed as a 24-inch CMP]. FS Date: 10/20/2020

Overview of levee crown, looking US

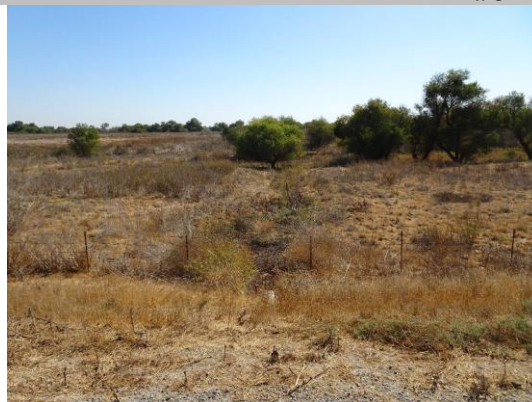
Photo 2 of 3 : UCIP\_FA\_2021\_64743\_90772.jpg

WS view: Pipe and flapgate visible on WS toe

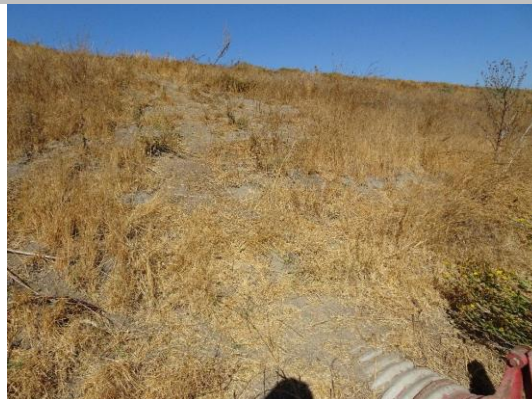
Photo 3 of 3 : UCIP\_FA\_2021\_64743\_90767.jpg

WS view: Slope WS pipe and flapgate

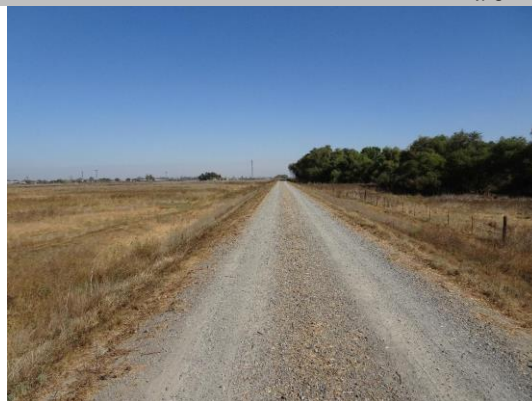
Photo 1 of 3 : UCIP\_FA\_2021\_64740\_90778.jpg

DS\_ID:19623  
 FS\_ID:64740  
 EP\_NO: N/A  
 Repair Type: Non-Urgent  
 EVAL Issue: Unauthorized Encroachment, installed decades prior  
 Crossing Status: Found  
 UCIP Comments: 10/20/2020 Record remains Non-Urgent. No permit was found authorizing this encroachment. CVFPB will need to review crossing to determine owner. DWR DMP has not found internal issues, LOF between 1 and 2. Recommend inspection in 5 years. (B. Singh - GEI, O. Magana - DWR UCIP)04/09/2014 Dense vegetation limits the inspector's visibility to identify signs of pipe failure (leaks) along the slope. Recommend removing vegetation along pipe alignment to conduct proper inspection of structure. (W. Wylie - DWR UCIP)  
 FIELD\_STRUCT\_DESC: 24-inch corrugated metal gravity drainage pipe through the levee, 9.1 feet below the crown. Flap gate on the waterside (WS) end. Brass cap No. 80 bench mark (BM) on the headwall on the landside (LS). [Additional Reference(s): DWR Levee Log, 2002 (HLM 8.95), listed as a 24-inch corrugated metal pipe (CMP). USACE San Joaquin O&M, Unit 601 Part 1 (SJR601.1), 1967, Revised 25 May 2011, (HLM 8.93), listed as a 24-inch CMP].

Overview of levee crown, looking US

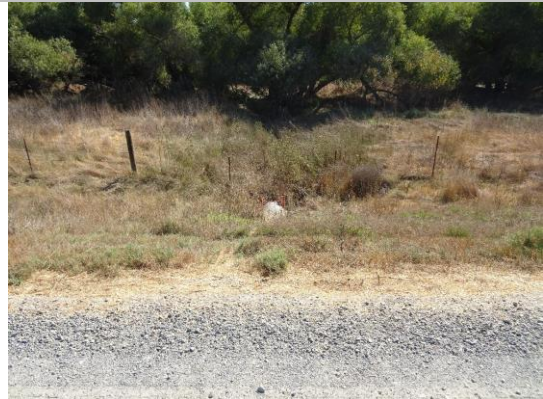
Photo 2 of 3 : UCIP\_FA\_2021\_64740\_90780.jpg

WS view: Pipe and flapgate visible at WS toe

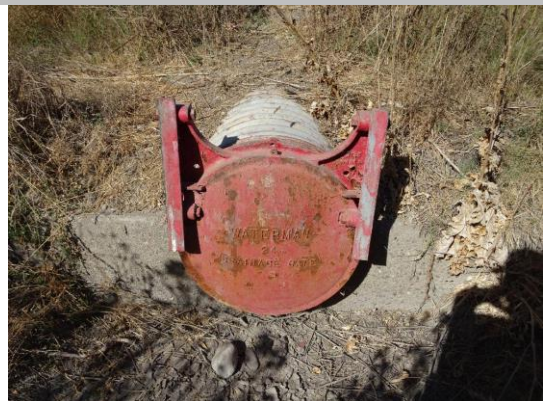
Photo 3 of 3 : UCIP\_FA\_2021\_64740\_90776.jpg

WS view: Pipe, flapgate, and headwall at WS toe

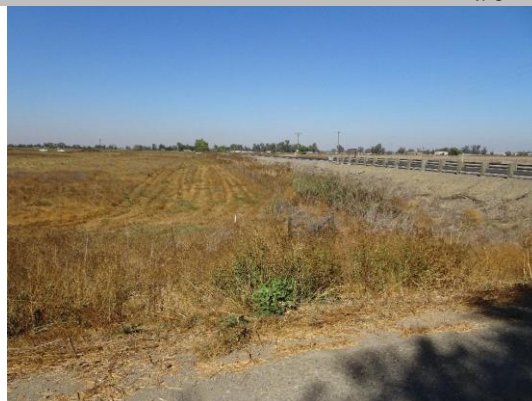
Photo 1 of 3 : UCIP\_FA\_2021\_64741\_90783.jpg

Comment Code					
Inspector Comment					
DS_ID:19624 FS_ID:64741 EP_NO: 12156 Repair Type: Urgent EVAL Issue: Flood Risk Crossing Status: Found UCIP Comments: 10/20/2020 Record remains Urgent. There is no operating gate that will prevent flows from the WS to LS. Dense vegetation prevented a full inspection of this crossing. Need to contact owner to clear the dense vegetation on both the WS and the LS to be able to perform proper inspection of crossing. DWR DMP has completed a geophysical study in this area and plans to complete an internal inspection of this pipe. The pipe is scheduled for an internal inspection in 2021. (B. Singh - GEI, O. Magana - DWR UCIP)11/01/2018 Dense vegetation prevented a full inspection of this crossing. Assumed crossing remains the same as the 2016 inspection. Crossing remains Urgent due to signs of pipe being rusted through visible from the WS. Need to contact owner to clear the dense vegetation on both the WS and the LS to be able to perform proper inspection of crossing. (O. Magana - DWR UCIP)07/19/2016 same as previous inspection--pipe rusted through. Sediment visible inside LS pipe; walkway wood panels have dry rot and appears to be unsafe to use. (O. Magana - DWR UCIP)04/09/2014 Slide gate rusted through and open on WS toe. Inlet appears to be obscured or covered in soil at LS toe. Also dense vegetation on waterward and landward sides. Need to contact owner to contact CVFPB to address issue. (W. Wylie - DWR UCIP) FIELD_STRUCT_DESC: 26-inch steel pipe sleeved through a 30-inch reinforced concrete gravity drainage pipe through the levee, 7.3 feet below the crown. Annular space grouted between the two pipes. Two concrete cutoff walls in the center of the levee. Slide gate with elevated walkway access on the waterside (WS) end. 6-inch thick concrete headwall on the WS end. Concrete wing walls on each end. (Plans to install a 30-inch storm drainage pipe with a valve through the levee authorized under Permit No. 12156, 1977 - Merquin County Water District). (Additional Related Permit(s): Permit No. 12156-A, 1978 - Merquin County Water District). [Additional Reference(s): DWR Levee Log, 2002 (HLM 9.01), listed as a 30-inch concrete pipe]. FS Date: 10/20/2020

LS view: View of LS toe from levee crown

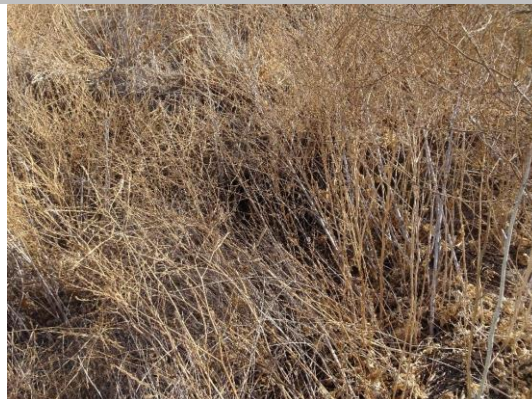
Photo 2 of 3 : UCIP\_FA\_2021\_64741\_92418.jpg

LS view: concrete headwall slightly visible on LS.

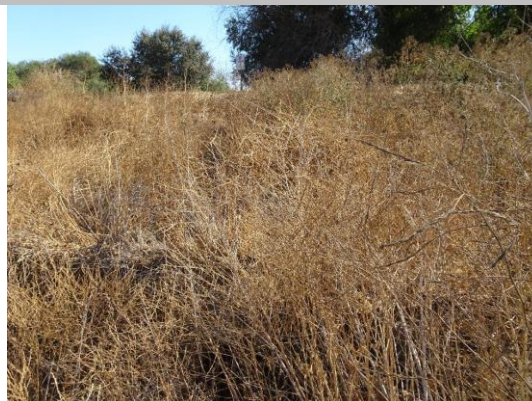
Photo 3 of 3 : UCIP\_FA\_2021\_64741\_92419.jpg

LS view: dense vegetation prevented visible evidence of inlets.

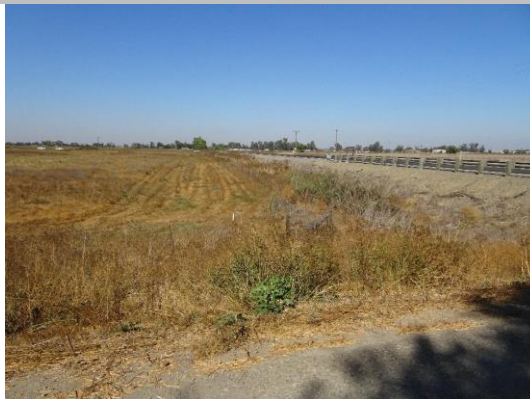
Photo 1 of 3 : UCIP\_FA\_2021\_64742\_90789.jpg

Comment Code						
Inspector Comment						
DS_ID:19625 FS_ID:64742 EP_NO: N/A Repair Type: Non-Urgent EVAL Issue: Limited Inspection/No UCIP Evaluation Crossing Status: Found UCIP Comments: 10/20/2020 Record remains Non-Urgent. As in previous inspection, dense vegetation inhibited proper inspection of the pipe and slope. No permit was found authorizing this encroachment. CVFPB will need to review crossing to determine owner. DWR DMP internal inspection is pending and scheduled for 2021. (B. Singh - GEI, O. Magana - DWR UCIP)04/09/2014 Dense vegetation limits the inspector's visibility to identify signs of pipe failure (leaks) along the slope. Recommend removing vegetation along pipe alignment to conduct proper inspection of structure. Some sediment buildup in pipe. (W. Wylie - DWR UCIP) FIELD_STRUCT_DESC: 36-inch corrugated metal gravity drainage pipe through the levee, 10 feet below the crown. Flap gate on the waterside (WS) end. Brass cap No. 80 bench mark (BM) on the headwall on the landside (LS). [Additional Reference(s): DWR Levee Log, 2002 (HLM 9.01), listed as a 36-inch corrugated metal pipe (CMP). USACE San Joaquin O&M Manual, Unit 601 Part 1 (SJR601.1), 1967, Revised 25 May 2011, (HLM 9.00), listed as a 36-inch CMP]. FS Date: 10/20/2020

LS view: View toward LS toe. Headwall not visible due to high vegetation.

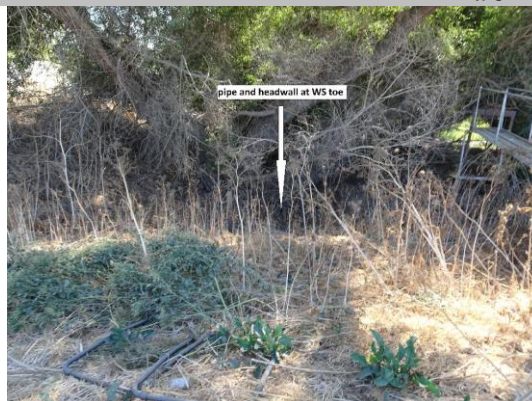
Photo 3 of 3 : UCIP\_FA\_2021\_64742\_90791.jpg

WS view: Pipe visible at WS toe, but low accessibility due to vegetation.

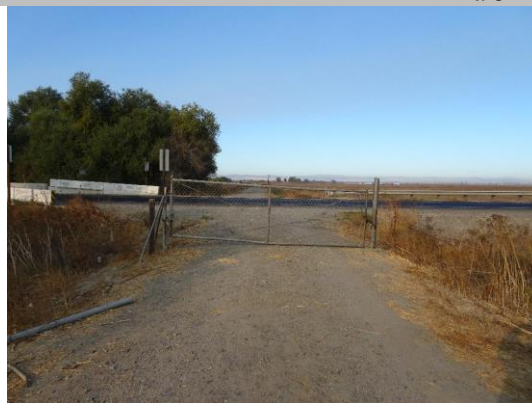
Photo 1 of 3 : UCIP\_FA\_2021\_64744\_90906.jpg

DS\_ID:19626  
FS\_ID:64744  
EP\_NO: N/A  
Repair Type: Non-Urgent  
EVAL Issue: Limited Inspection/No UCIP Evaluation  
Crossing Status: Found  
UCIP Comments: 10/21/2020 Record remains Non-Urgent. Dense vegetation inhibited proper inspection of pipe condition. No permit was found authorizing this encroachment. CVFPB will need to review crossing to determine owner. DWR DMP internal inspection is pending and scheduled for 2021. (B. Singh - GEI, O. Magana - DWR UCIP)04/09/2014 Dense vegetation limits the inspector's visibility to identify signs of pipe failure (leaks) along the slope. Recommend removing vegetation along pipe alignment to conduct proper inspection of structure. (W. Wylie - DWR UCIP)  
FIELD\_STRUCT\_DESC: 24-inch corrugated metal gravity drainage pipe through the levee, 10 feet below the crown. Flap gate on the waterside (WS) end. Brass cap No. 80 bench mark (BM) on the headwall on the landside (LS). [Additional Reference(s): DWR Levee Log, 2002 (HLM 9.03), listed as a 24-inch corrugated metal pipe (CMP). USACE San Joaquin O&M Manual, Unit 601 Part 1 (SJR601.1), 1967, Revised 25 May 2011, (HLM 9.03), listed as a 24-inch CMP].

Overview of levee crown looking downstream.

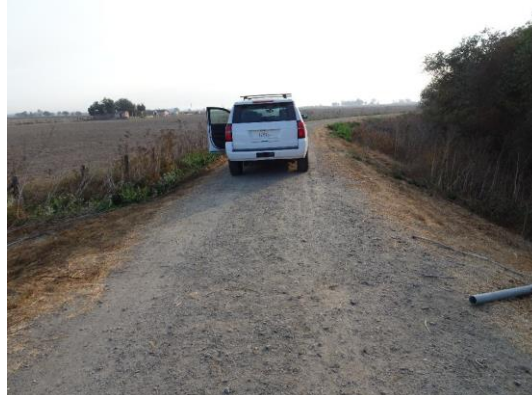
Photo 2 of 3 : UCIP\_FA\_2021\_64744\_92421.jpg

Overview of levee crown looking upstream.

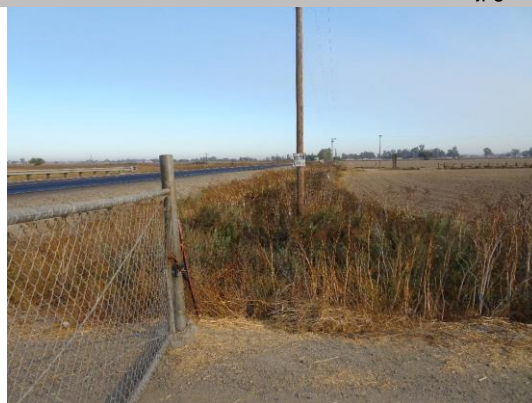
Photo 3 of 3 : UCIP\_FA\_2021\_64744\_90907.jpg

LS view: overview of LS

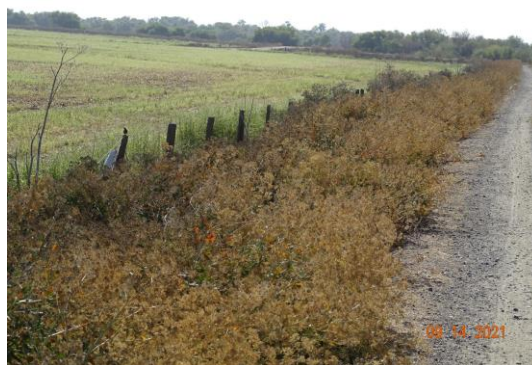
Photo 1 of 1 : FA\_2021\_NA0010\_118\_129\_20210927\_00295.jpg

LM Start	9.00	Rating **	U	Issue No.	129
LM End	9.61	Issue Type +	Ma	Location *	LS
Category	Earthen Levee			GPS Latitude/Longitude	
				Start	End
Item	Vegetation			37.297481 °	37.295132 °
				-120.851022 °	-120.840839 °
DWR ID	DWR_NA0010_01_f_2021_129				
Comment Code					
V1 : Control annual grass and weeds on the levee slopes and easements.					
Inspector Comment

View of the landside slope looking upstream. (Fall 2021)

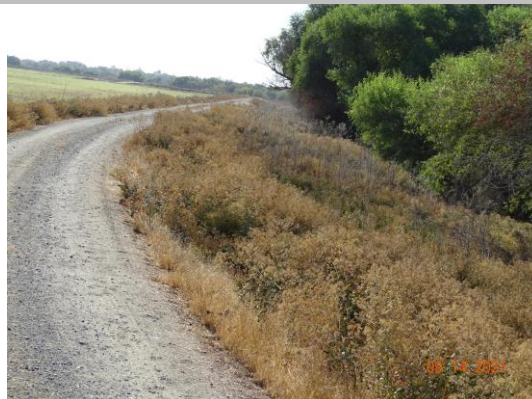
Photo 1 of 1 : FA\_2021\_NA0010\_118\_130\_20210927\_00296.jpg

LM Start	9.02	Rating **	U	Issue No.	130
LM End	9.61	Issue Type +	Ma	Location *	WS
Category	Earthen Levee			GPS Latitude/Longitude	
				Start	End
Item	Vegetation			37.297480 °	37.295223 °
				-120.850689 °	-120.840947 °
DWR ID	DWR_NA0010_01_f _ 2021_130				
Comment Code					
V1 : Control annual grass and weeds on the levee slopes and easements.					
Inspector Comment

View of the waterside slope looking upstream. (Fall 2021)

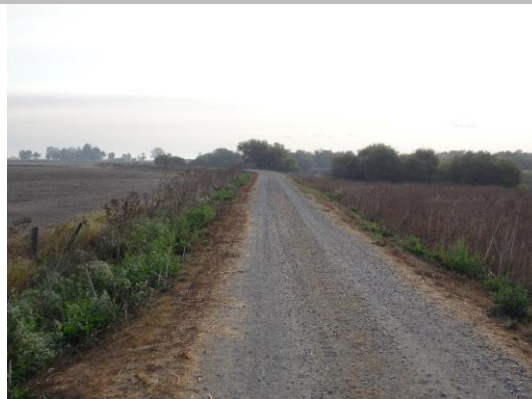
Photo 1 of 3 : UCIP\_FA\_2021\_64745\_90910.jpg

Comment Code						
Inspector Comment						
DS_ID:19627 FS_ID:64745 EP_NO: N/A Repair Type: Urgent EVAL Issue: Pipe Integrity Crossing Status: Found UCIP Comments: 10/21/2020 Record has been updated from Non-Urgent to Urgent. DWR DMP has found integrity issues, LOF between 5 and 6. Scouring observed about 2 feet downstream of pipe at WS toe. Crossing will be monitored until funding becomes available to address. No permit was found authorizing this encroachment. CVFPB will need to review crossing to determine owner. (B. Singh - GEI, O. Magana - DWR UCIP)04/09/2014 Dense vegetation limits the inspector's visibility to identify signs of pipe failure (leaks) along the slope. Recommend removing vegetation along pipe alignment to conduct proper inspection of structure. (W. Wylie - DWR UCIP ) FIELD_STRUCT_DESC: 24-inch corrugated metal gravity drainage pipe through the levee, 8.6 feet below the crown. Concrete drop inlet at the landside (LS) toe. Flap gate on the waterside (WS) end. Brass cap No. 80 bench mark (BM) on the headwall on the LS. [Additional Reference(s): DWR Levee Log, 2002 (HLM 9.39), listed as a 24-inch corrugated metal pipe (CMP). USACE San Joaquin O&M Manual, Unit 601 Part 1 (SJR601.1), 1967, Revised 25 May 2011, (HLM 9.37), listed as 24-inch CMP]. FS Date: 10/21/2020

Overview of levee crown

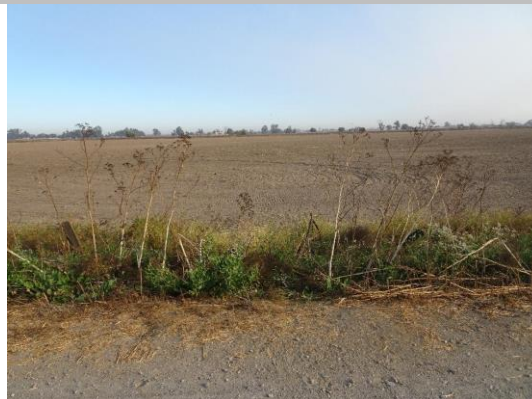
Photo 2 of 3 : UCIP\_FA\_2021\_64745\_90912.jpg

LS view: overview of LS

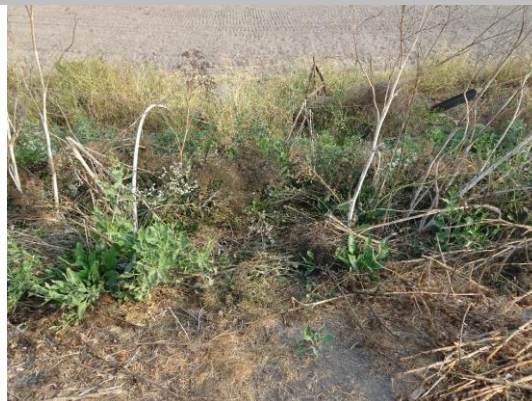
Photo 3 of 3 : UCIP\_FA\_2021\_64745\_90911.jpg

LS view: View of LS slope from levee crown

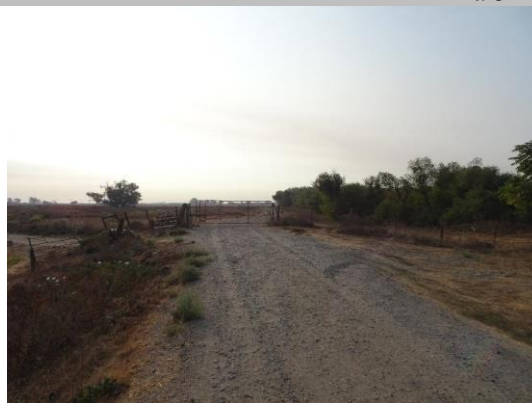
Photo 1 of 3 : UCIP\_FA\_2021\_64746\_90915.jpg

Comment Code					
Inspector Comment					
DS_ID:19628 FS_ID:64746 EP_NO: N/A Repair Type: Non-Urgent EVAL Issue: Unauthorized Encroachment, installed decades prior Crossing Status: Found UCIP Comments: 10/21/2020 Record has been updated from No Action Needed to Non-Urgent. No permit was found authorizing this encroachment. CVFPB will need to review crossing to determine owner. DWR DMP has not found internal issues, LOF between 1 and 2. Recommend inspection in 5 years. (B. Singh - GEI, O. Magana - DWR UCIP) FIELD_STRUCT_DESC: 24-inch corrugated metal gravity drainage pipe through the levee, 4.5 feet below the crown. Flap gate on the waterside (WS) end. Brass cap No. 80 bench mark (BM) on the headwall on the landside (LS). [Additional Reference(s): DWR Levee Log, 2002 (HLM 9.68), listed as a 24-inch corrugated metal pipe (CMP). USACE San Joaquin O&M Manual, Unit 601 Part 1 (SJR601.1), 1967, Revised 25 May 2011, (HLM 9.67), listed as a 24-inch CMP]. FS Date: 10/21/2020

Overview of levee crown

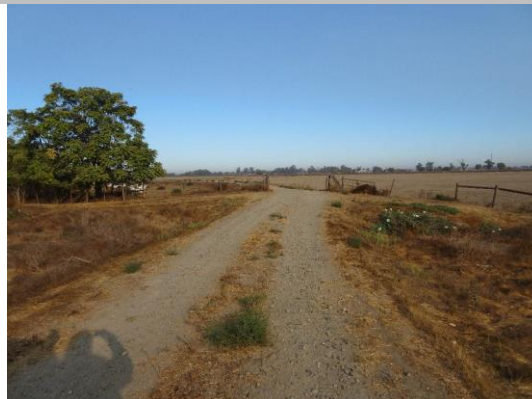
Photo 2 of 3 : UCIP\_FA\_2021\_64746\_92422.jpg

Overview of levee crown looking downstream towards pipe crossing.

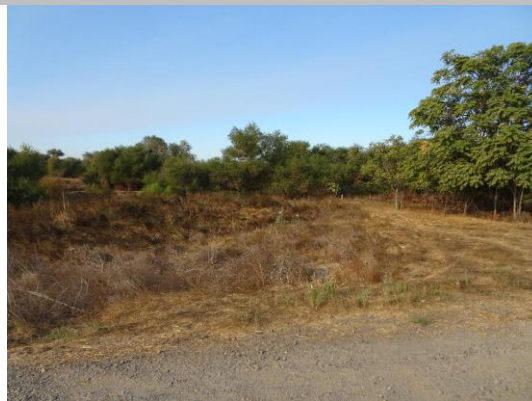
Photo 3 of 3 : UCIP\_FA\_2021\_64746\_90916.jpg

WS view: overview of WS

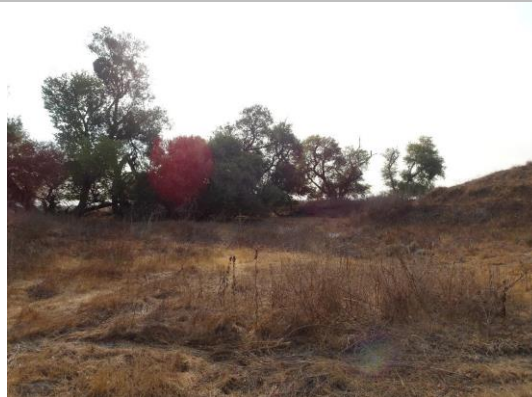
Photo 3 of 3 : UCIP\_FA\_2021\_64747\_92745.jpg

Comment Code						
Inspector Comment						
DS_ID:19976 FS_ID:64747 EP_NO: N/A Repair Type: Non-Urgent EVAL Issue: Unauthorized Encroachment Crossing Status: Not Found UCIP Comments: 10/21/2020 Record has been updated from No Action Needed to Non-Urgent. No levee present at this location. Pipe referenced at this location does not exist. Only found two culverts at grade in the WS. No permit was found authorizing this encroachment. CVFPB will need to review crossing to determine owner. (O. Magana - DWR UCIP, B. Singh - GEI)04/09/2014 Appears to have been washed out at levee breach. (W. Wylie - DWR UCIP) FIELD_STRUCT_DESC: 24-inch corrugated metal gravity drainage pipe through the levee, at an unknown depth. Cross fence with metal drive gate on the levee crown. Access on the waterside (WS). FS Date: 10/21/2020

Overview of where levee is no longer present. Location historic levee break, levee absent.

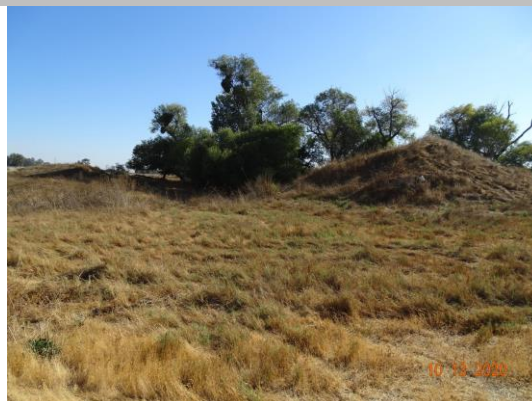
Photo 1 of 1 : FA\_2021\_NA0010\_118\_112\_20210830\_00014.jpg

LM Start	9.89	Rating **	A/W	Issue No.	112
LM End	9.90	Issue Type +	Ma	Location *	CR
Category	Earthen Levee			GPS Latitude/Longitude	
				Start	End
Item	Erosion / Bank Caving			37.291796 °	37.291581 °
				-120.839497 °	-120.839718 °
DWR ID	DWR_NA0010_01_f _ 2017_112				
Comment Code					
E1 : Note and monitor erosion site.					
Inspector Comment					
Landowner degraded levee in the 1970's because water on LS was flooding his property. Landowner has prevented efforts to restore levee. LMA has stated that no water from the waterside of the levee has ever backed up through the degraded levee and caused flooding.

Looking east at the levee breach. (Fall 2020)

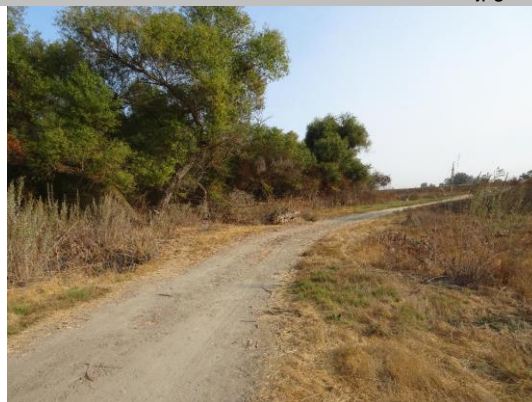
Photo 2 of 3 : UCIP\_FA\_2021\_64748\_91046.jpg

Comment Code					
Inspector Comment					
DS_ID:19556 FS_ID:64748 EP_NO: N/A Repair Type: Non-Urgent EVAL Issue: Unauthorized Encroachment Crossing Status: Not Found UCIP Comments: 10/21/2020 Record has been updated from No Action Needed to Non-Urgent. No levee present at this location. Pipe referenced at this location does not exist. Only found two culverts at grade in the WS. No permit was found authorizing this encroachment. CVFPB will need to review crossing to determine owner. (B. Singh - GEI, O. Magana - DWR UCIP) FIELD_STRUCT_DESC: 24-inch corrugated metal gravity drainage pipe through the levee, 6 feet below the crown. Flap gate on the waterside (WS) end. Brass cap No. 70 bench mark (BM) on the headwall on the landside (LS). [Additional Reference(s): DWR Levee Log, 2002 (HLM 9.91), listed as a 24-inch corrugated metal pipe (CMP). USACE San Joaquin O&M Manual, Unit 601 Part 1 (SJR601.1), 1967, Revised 25 May 2011, (HLM 9.93), listed as a 24-inch CMP]. FS Date: 10/21/2020

Overview access road looking downstream.

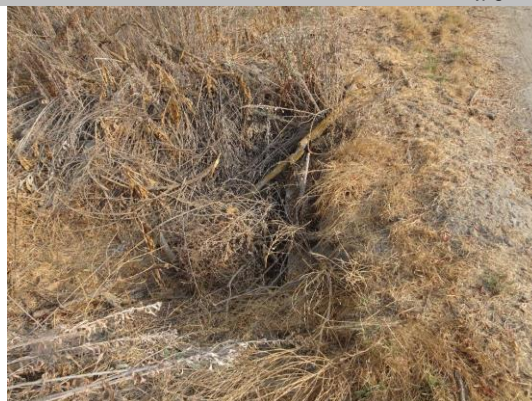
Photo 3 of 3 : UCIP\_FA\_2021\_64748\_91047.jpg

Culverts underneath access road visible on WS

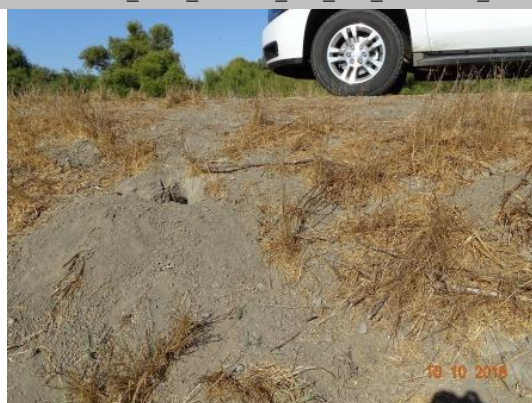
Photo 1 of 1 : FA\_2021\_NA0010\_118\_120\_20210830\_00021.jpg

LM Start	9.94	Rating **	U	Issue No.	120
LM End	9.97	Issue Type +	Ma	Location *	LS
Category	Earthen Levee			GPS Latitude/Longitude	
				Start	End
Item	Animal Control			37.290994 °	37.290673 °
				-120.839758 °	-120.839988 °
DWR ID	DWR_NA0010_01_f_2018_120				
Comment Code					
A3 : No rodents visible, but rodent burrows visible; need to backfill and compact or grout burrows.					
Inspector Comment					
Rodent burrows observed in this section with large amount of material displaced.

View of rodent burrow in the landside slope. (Fall 2018)
