## Flood Control Project Maintenance Levee Inspections

### Fall 2021 Levee Maintenance Deficiency Summary Report

#### San Joaquin River Basin

NA0010 Lower San Joaquin Levee District	Overall LMA Rating	Total LMA Miles							
	U	191.27							
Rated Item	Maintenance Deficiency				Enforcement		Design & System Obsolescence		
	M Miles	U Miles	M + 4U Miles	Threshold %	M Miles	U Miles	M Miles	U Miles	
<i>Earthen Levee</i>									
Vegetation	47.00	9.57	85.28	44.59%					
Trim / Thin Trees	0.10		0.10	0.05%					
Encroachments	0.23	0.02	0.31	0.16%	9.29	0.59			
Animal Control	7.67	2.19	16.43	8.59%					
Slope Stability	0.05	0.01	0.09	0.05%					
Erosion / Bank Caving	0.13	0.81	3.37	1.76%					
Crown Surface / Depressions / Rutting	0.01		0.01	0.01%					
Repair Gates	0.02	0.02	0.10	0.05%					
<i>Rivers, Channels &amp; Designated Floodways</i>									
Encroachments					0.01	0.01			
<i>Supplemental</i>									
DWR Erosion Survey	0.12	0.17	0.80	0.42%					
DWR UCIP Field Study					1.29	0.05			
DWR UCIP LMA Responsibility									
<i>LMA Totals:</i>	55.33	12.79	106.49	55.67%	10.59	0.65	0.00	0.00

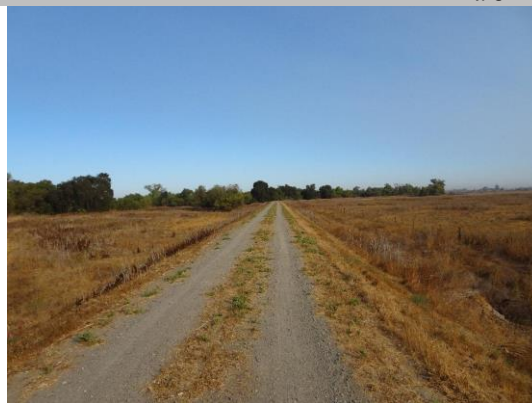
Photo 1 of 3 : UCIP\_FA\_2021\_64858\_90922.jpg

Comment Code						
Inspector Comment						
DS_ID:19629 FS_ID:64858 EP_NO: N/A Repair Type: Non-Urgent EVAL Issue: Unauthorized Encroachment, installed decades prior Crossing Status: Found UCIP Comments: 10/21/2020 Record remains Non-Urgent. No permit was found authorizing this encroachment. CVFPB will need to review crossing to determine owner. DWR DMP has not found internal issues, LOF between 1 and 2. Recommend inspection in 5 years. (B. Singh - GEI, O. Magana - DWR UCIP)04/09/2014 Dense vegetation blocks waterward and landward toes Recommend removing vegetation from both toes. Also sediment buildup in pipe visible from landward side. (W. Wylie - UCIP DMP) FIELD_STRUCT_DESC: 24-inch corrugated metal gravity drainage pipe through the levee, 9 feet below the crown. Flap gate on the waterside (WS) end. Brass cap No. 69 bench mark (BM) on the headwall on the landside (LS). [Additional Reference(s): DWR Levee Log, 2002 (HLM 10.24), listed as a 24-inch corrugated metal pipe (CMP). USACE San Joaquin O&M Manual, Unit 601 Part 1 (SJR601.1), 1967, Revised 25 May 2011, (HLM 10.23), listed as a 24-inch CMP]. FS Date: 10/21/2020

Overview of levee crown

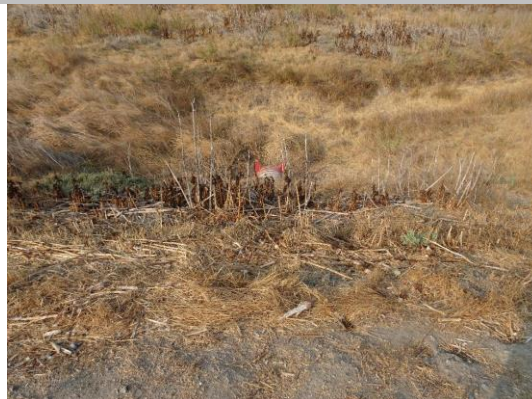
Photo 2 of 3 : UCIP\_FA\_2021\_64858\_90923.jpg

WS view: Pipe and flapgate visible at WS toe

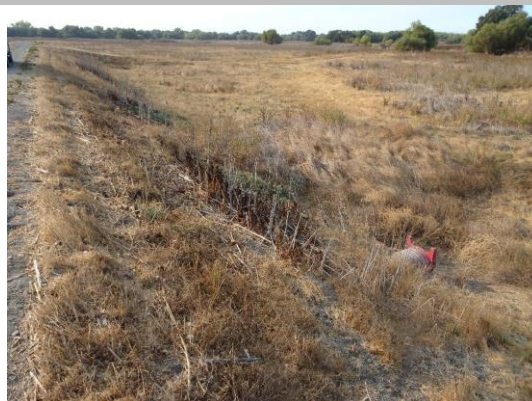
Photo 3 of 3 : UCIP\_FA\_2021\_64858\_90926.jpg

WS view: WS slope profile

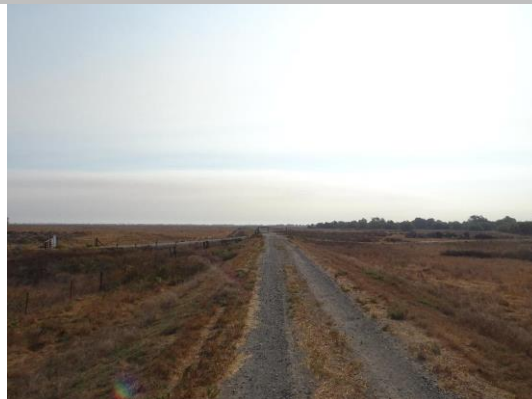
Photo 1 of 3 : UCIP\_FA\_2021\_64859\_92750.jpg

Comment Code						
Inspector Comment						
DS_ID:19630 FS_ID:64859 EP_NO: N/A Repair Type: Non-Urgent EVAL Issue: Unauthorized Encroachment, installed decades prior Crossing Status: Found UCIP Comments: 10/21/2020 Record has been updated from No Action Needed to Non-Urgent. No permit was found authorizing this encroachment. CVFPB will need to review crossing to determine owner. DWR DMP has not found internal issues, LOF between 1 and 2. Recommend inspection in 5 years. (B. Singh - GEI, O. Magana - DWR UCIP) FIELD_STRUCT_DESC: 24-inch corrugated metal gravity drainage pipe through the levee, 7 feet below the crown. Flap gate on the waterside (WS) end. Brass cap No. 68 bench mark (BM) on the headwall on the landside (LS). [Additional Reference(s): DWR Levee Log, 2002 (HLM 10.73), listed as a 24-inch corrugated metal pipe (CMP). USACE San Joaquin O&M Manual, Unit 601 Part 1 (SJR601.1), 1967, Revised 25 May 2011, (HLM 10.72), listed as a 24-inch CMP]. FS Date: 10/21/2020

Overview of levee crown, looking upstream towards crossing.

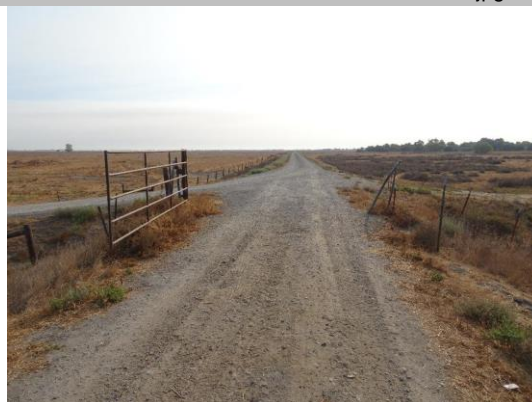
Photo 2 of 3 : UCIP\_FA\_2021\_64859\_90999.jpg

Overview of levee crown looking upstream

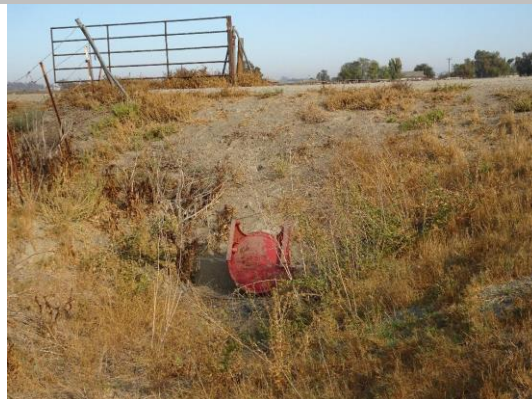
Photo 3 of 3 : UCIP\_FA\_2021\_64859\_91001.jpg

WS view: Pipe and flapgate visible at WS toe

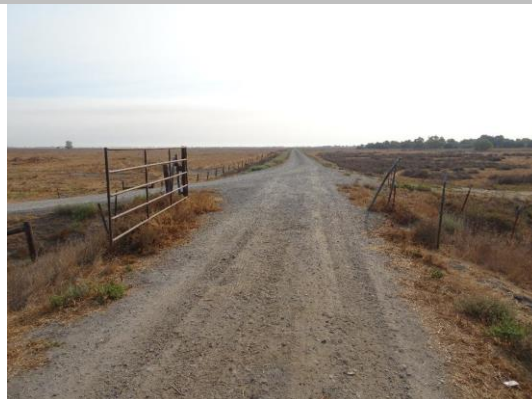
Photo 2 of 3 : UCIP\_FA\_2021\_64751\_91009.jpg

DS\_ID:19631  
 FS\_ID:64751  
 EP\_NO: N/A  
 Repair Type: Non-Urgent  
 EVAL Issue: Pipe Damage  
 Crossing Status: Found  
 UCIP Comments: 10/21/2020 Record has been updated from No Action Needed to Non-Urgent. DWR DMP has found integrity issues, LOF between 4 and 5. Crossing will be monitored until funding becomes available for rehabilitation. No permit was found authorizing this encroachment. CVFPB will need to review crossing to determine owner. Pipe material changes from CMP on the WS to concrete on the LS. (B. Singh - GEI, O. Magana - DWR UCIP)  
 FIELD\_STRUCT\_DESC: 24-inch corrugated metal gravity drainage pipe through the levee, 7 feet below the crown. Flap gate on the waterside (WS) end. Brass cap No. 67 bench mark (BM) on the headwall on the landside (LS). Pipe material changes from CMP (on WS) to concrete (on LS). [Additional Reference(s): DWR Levee Log, 2002 (HLM 10.74), listed as a 24-inch corrugated metal pipe (CMP). USACE San Joaquin O&M Manual, Unit 601 Part 1 (SJR601.1), 1967, Revised 25 May 2011, (HLM 10.72), listed as a 24-inch CMP].

Overview of levee crown looking upstream

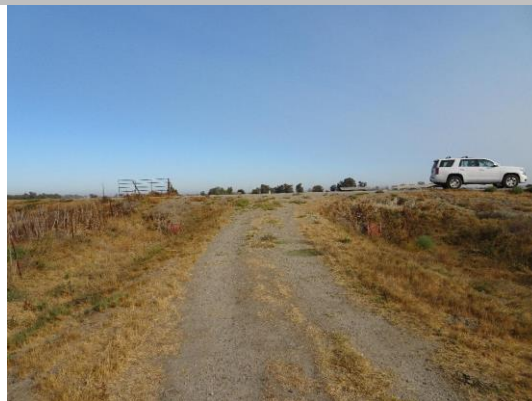
Photo 3 of 3 : UCIP\_FA\_2021\_64751\_92766.jpg

WS view: ramp located on WS with two crossing on either side. This crossing is located on the right side.

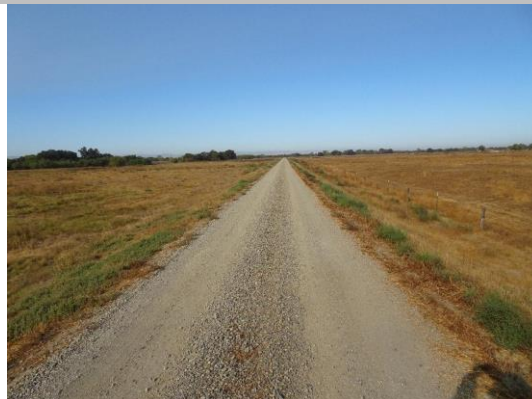
Photo 1 of 3 : UCIP\_FA\_2021\_64752\_90929.jpg

Comment Code						
Inspector Comment						
DS_ID:19632 FS_ID:64752 EP_NO: N/A Repair Type: Non-Urgent EVAL Issue: Unauthorized Encroachment, installed decades prior Crossing Status: Found UCIP Comments: 10/21/2020 Record remains Non-Urgent. No permit was found authorizing this encroachment. CVFPB will need to review crossing to determine owner. DWR DMP has not found internal issues, LOF between 1 and 2. Recommend inspection in 5 years. Dense vegetation previously recorded in the 2014 UCIP inspection has been cleared. (B. Singh - GEI, O. Magana - DWR UCIP)04/09/2014 Dense vegetation blocks landward headwall. Recommend removing excess vegetation on landward toe. (W. Wylie - DWR UCIP) FIELD_STRUCT_DESC: 24-inch corrugated metal gravity drainage pipe through the levee, 6 feet below the crown. Flap gate on the waterside (WS) end. Brass cap No. 66 bench mark (BM) on the headwall on the landside (LS). [Additional Reference(s): DWR Levee Log, 2002 (HLM 11.02), listed as a 24-inch corrugated metal pipe (CMP). USACE San Joaquin O&M Manual, Unit 601 Part 1 (SJR601.1), 1967, Revised 25 May 2011, (HLM 11.00), listed as a 24-inch CMP]. FS Date: 10/21/2020

Overview of levee crown looking upstream

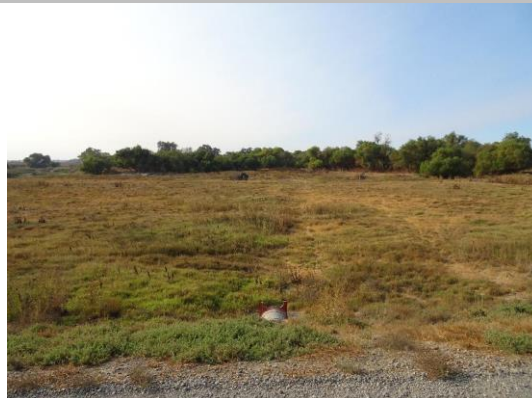
Photo 2 of 3 : UCIP\_FA\_2021\_64752\_90930.jpg

WS view: overview of WS

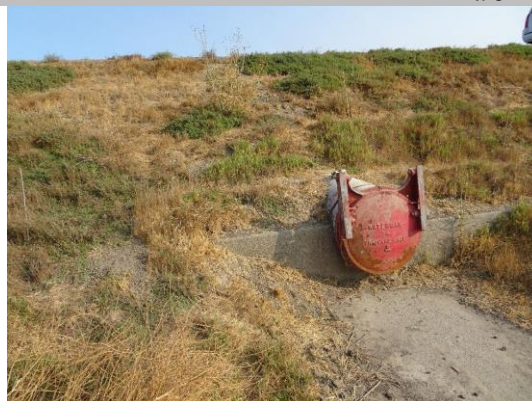
Photo 3 of 3 : UCIP\_FA\_2021\_64752\_90932.jpg

WS view: overview of WS slope

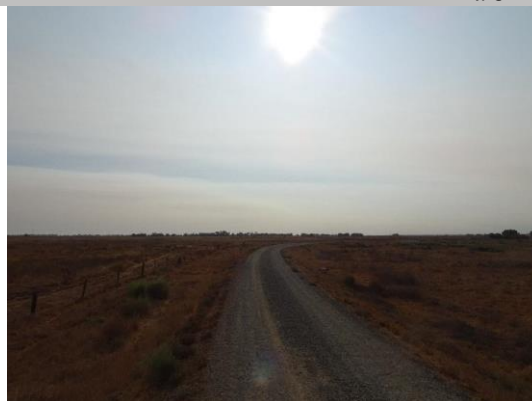
Photo 1 of 3 : UCIP\_FA\_2021\_64860\_92800.jpg

DS\_ID:19633  
 FS\_ID:64860  
 EP\_NO: N/A  
 Repair Type: Non-Urgent  
 EVAL Issue: Unauthorized Encroachment, installed decades prior  
 Crossing Status: Found  
 UCIP Comments: 10/21/2020 Record has been updated from No Action Needed to Non-Urgent. No permit was found authorizing this encroachment. CVFPB will need to review crossing to determine owner. DWR DMP has not found internal issues, LOF between 1 and 2. Recommend inspection in 5 years. (B. Singh - GEI, O. Magana - DWR UCIP)  
 FIELD\_STRUCT\_DESC: 24-inch corrugated metal gravity drainage pipe through the levee, 5 feet below the crown. Flap gate on the waterside (WS) end. Brass cap No. 65 bench mark (BM) on the headwall on the landside (LS). [Additional Reference(s): DWR Levee Log, 2002 (HLM 11.20), listed as a 24-inch corrugated metal pipe (CMP). USACE San Joaquin O&M Manual, Unit 601 Part 1 (SJR601.1), 1967, Revised 25 May 2011, (HLM 11.18), listed as a 24-inch CMP].

Overview of levee curve towards pipe crossing, looking upstream

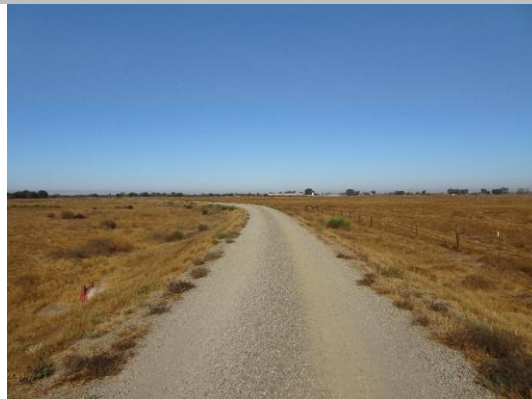
Photo 2 of 3 : UCIP\_FA\_2021\_64860\_90935.jpg

Overview of levee crown, looking upstream

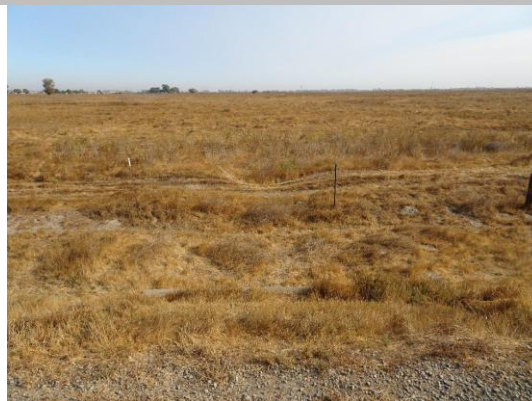
Photo 3 of 3 : UCIP\_FA\_2021\_64860\_90936.jpg

LS view: overview of LS

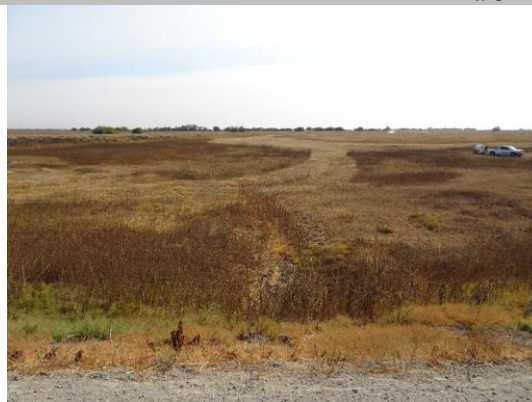
Photo 2 of 3 : UCIP\_FA\_2021\_64861\_90941.jpg

LS view: overview of LS

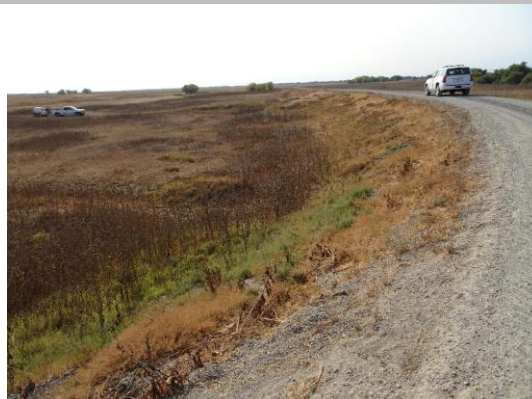
Photo 3 of 3 : UCIP\_FA\_2021\_64861\_92834.jpg

LS view: profile view of LS slope.

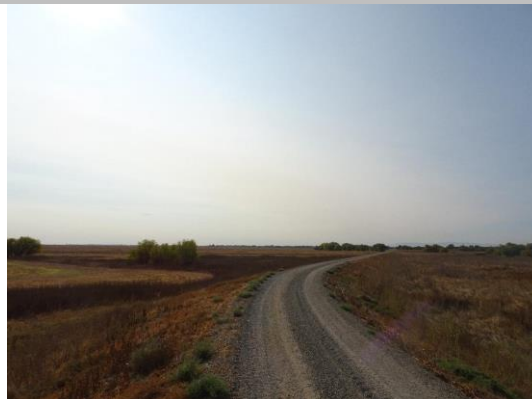
Photo 1 of 3 : UCIP\_FA\_2021\_64862\_92836.jpg

DS\_ID:19634  
 FS\_ID:64862  
 EP\_NO: N/A  
 Repair Type: Non-Urgent  
 EVAL Issue: Pipe Damage  
 Crossing Status: Found  
 UCIP Comments: 10/21/2020 Record remains Non-Urgent. Dense vegetation inhibited inspection of pipe and headwall on the LS toe. DWR DMP has found integrity issues, LOF between 4 and 5. Unable to locate pipe inlet on along the LS toe. Crossing will be monitored until funding becomes available for rehabilitation. No permit was found authorizing this encroachment. CVFPB will need to review crossing to determine owner. (B. Singh - GEI, O. Magana - DWR UCIP)04/25/2014 Need to contact owner--landward side has been buried. It appears that soil was removed from levee toe, immediately upstream, and used to pile soil at landward side at crossing. (O. Magana - DWR UCIP)  
 FIELD\_STRUCT\_DESC: 24-inch corrugated metal gravity drainage pipe through the levee, 10 feet below the crown. Flap gate on the waterside (WS) end. Brass cap No. 62 bench mark (BM) on the headwall on the landside (LS). [Additional Reference(s): DWR Levee Log, 2002 (HLM 11.48), listed as a 24-inch corrugated metal pipe (CMP). USACE San Joaquin O&M Manual, Unit 601 Part 1 (SJR601.1), 1967, Revised 25 May 2011, (HLM 11.48), listed as a 24-inch CMP].

Overview of levee crown looking upstream towards pipe crossing, photo 1 of 2.

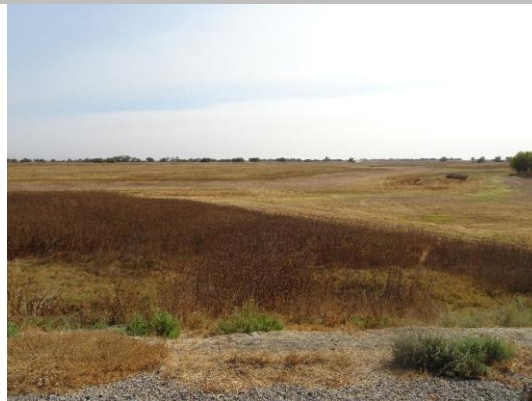
Photo 3 of 3 : UCIP\_FA\_2021\_64862\_90949.jpg

LS view: overview of LS.

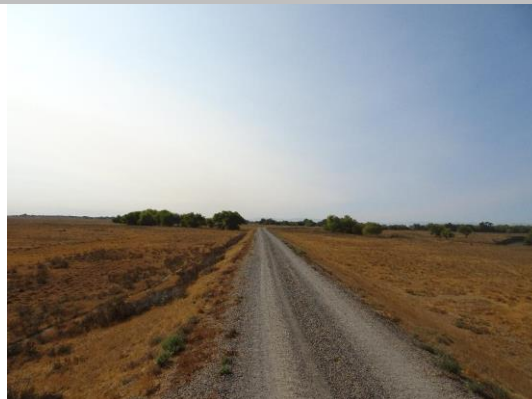
Photo 1 of 3 : UCIP\_FA\_2021\_64863\_90950.jpg

DS\_ID:19635  
FS\_ID:64863  
EP\_NO: N/A  
Repair Type: Non-Urgent  
EVAL Issue: Geophysical Evaluation (Confirmed)  
Crossing Status: Found  
UCIP Comments: 10/21/2020 Record remains Non-Urgent. DWR DMP geophysics study found evidence of pipe at 37.269697, -120.826430 (modified levee mile coordinates 37.269657, -120.826471 using UCIP calculator). Pipe and flap gate previously found on the WS toe were covered by dry vegetation preventing proper UCIP inspection. Recommend removal of excess vegetation to conduct a proper inspection of this structure through the levee. The pipe inlet and concrete headwall are buried on the LS toe. No permit was found authorizing this encroachment. CVFPB will need to review crossing to determine owner. (B. Singh - GEI, O. Magana - DWR UCIP)04/25/2014 Crossing is non-functional --landward side is buried. Debris found on landward side (channel). Dense vegetation found on waterward slope. Recommend contacting owner to determine status of crossing. If crossing is no longer used need to coordinate with CVFPB for proper abandonment. (O. Magana - DWR UCIP)

Overview of levee crown

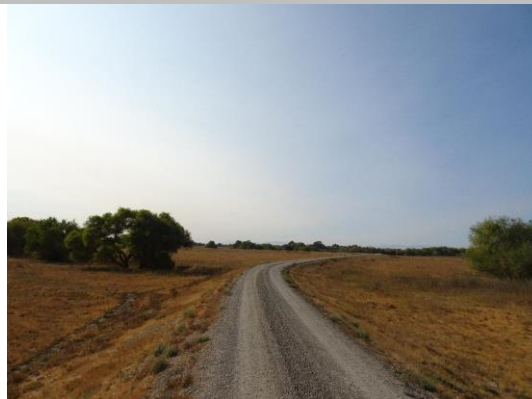
Photo 2 of 3 : UCIP\_FA\_2021\_64863\_92838.jpg

Overview of levee crown looking upstream towards pipe.

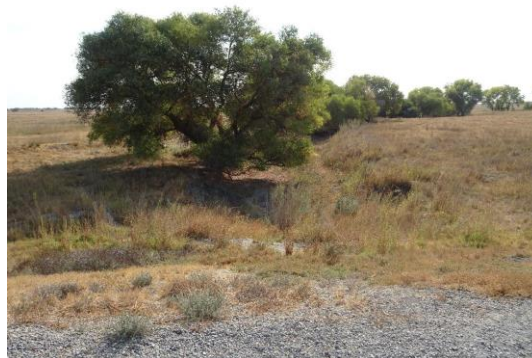
Photo 3 of 3 : UCIP\_FA\_2021\_64863\_90953.jpg

LS view: overview of LS

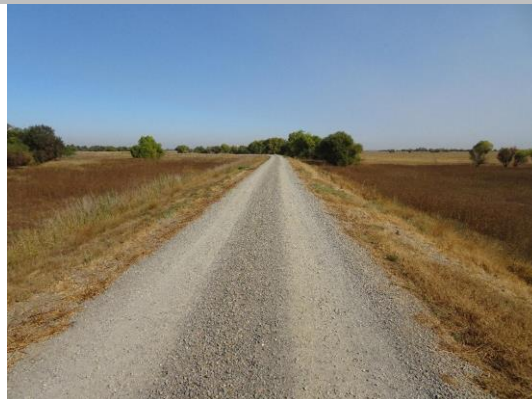
Photo 1 of 3 : UCIP\_FA\_2021\_64792\_90956.jpg

DS\_ID:19636  
FS\_ID:64792  
EP\_NO: N/A  
Repair Type: Non-Urgent  
EVAL Issue: Limited Inspection/No UCIP Evaluation  
Crossing Status: Found  
UCIP Comments: 10/21/2020 Record remains Non-Urgent. Dense vegetation inhibited proper inspection of the pipe on the LS and WS toes. No permit was found authorizing this encroachment. CVFPB will need to review crossing to determine owner. DWR DMP internal inspection is pending and scheduled for 2021. (B. Singh - GEI, O. Magana - DWR UCIP)04/25/2014 Crossing is non-functional -- landward side is buried. Dense vegetation found on waterward slope. Recommend contacting owner to determine status of crossing. If crossing is no longer used need to coordinate with CVFPB for proper abandonment. (O. Magana - DWR UCIP)  
FIELD\_STRUCT\_DESC: 24-inch corrugated metal gravity drainage pipe through the levee, 12.4 feet below the crown. Flap gate on the waterside (WS) end. Brass cap No. 60 bench mark (BM) on the headwall on the landside (LS). [Additional Reference(s): DWR Levee Log, 2002 (HLM 12.12), listed as a 24-inch corrugated metal pipe (CMP). USACE San Joaquin O&M Manual, Unit 601 Part 1 (SJR601.1), 1967, Revised 25 May 2011, (HLM 12.11), listed as a 24-inch CMP].

Overview of levee crown looking upstream.

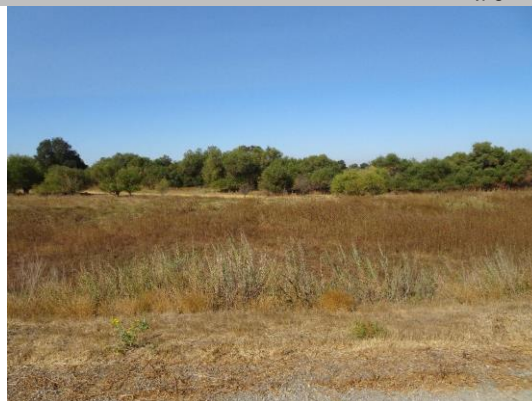
Photo 2 of 3 : UCIP\_FA\_2021\_64792\_90958.jpg

WS view: overview of WS

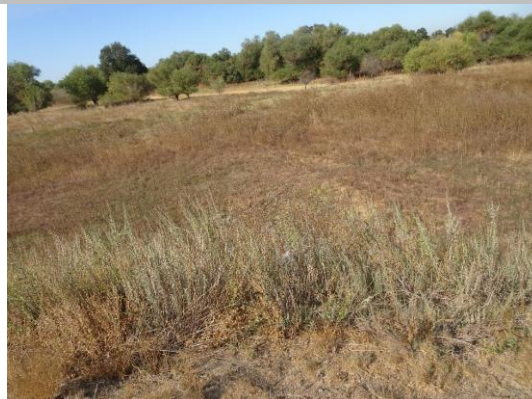
Photo 3 of 3 : UCIP\_FA\_2021\_64792\_90960.jpg

WS view: dense vegetation near WS toe.

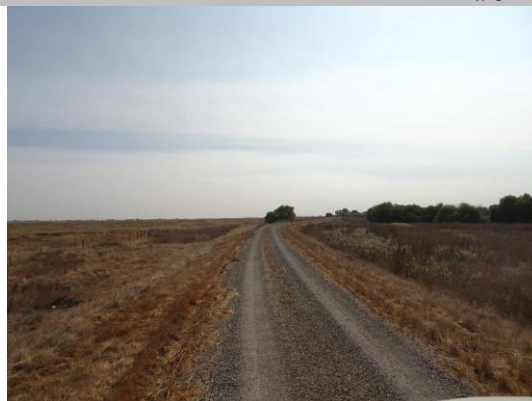
Photo 1 of 3 : UCIP\_FA\_2021\_64794\_92843.jpg

DS\_ID:19637  
 FS\_ID:64794  
 EP\_NO: N/A  
 Repair Type: Non-Urgent  
 EVAL Issue: Pipe Damage  
 Crossing Status: Found  
 UCIP Comments: 10/21/2020 Record remains Non-Urgent. DWR DMP has found integrity issues, LOF between 4 and 5. Crossing will be monitored until funding becomes available for rehabilitation. Proper inspection inhibited by dense vegetation. Recommend vegetation removal along pipe alignment. No permit was found authorizing this encroachment. CVFPB will need to review crossing to determine owner. (B. Singh - GEI, O. Magana - DWR UCIP)04/25/2014 Concrete headwall on landward side blocked by debris. Dense vegetation limits the inspector's visibility to identify signs of pipe failure (leaks) along the landward slope. Recommend removing vegetation along pipe alignment to conduct proper inspection of crossing. (O. Magana - DWR UCIP)  
 FIELD\_STRUCT\_DESC: 24-inch corrugated metal gravity drainage pipe through the levee, 9.5 feet below the crown. Flap gate on the waterside (WS) end. Brass cap No. 60 bench mark (BM) on the headwall on the landside (LS). [Additional Reference(s): DWR Levee Log, 2002 (HLM 12.95), listed as a 24-inch corrugated metal pipe (CMP). USACE San Joaquin O&M Manual, Unit 601 Part 1 (SJR601.1), 1967, Revised 25 May 2011, (HLM 12.94), listed as a 24-inch CMP].

Overview of levee crown looking upstream towards pipe crossing past curve.

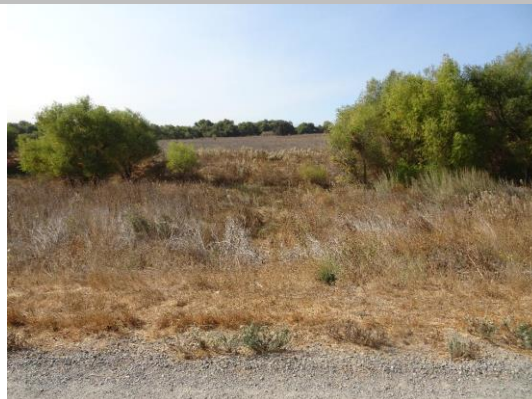
Photo 2 of 3 : UCIP\_FA\_2021\_64794\_90965.jpg

WS view: overview of WS

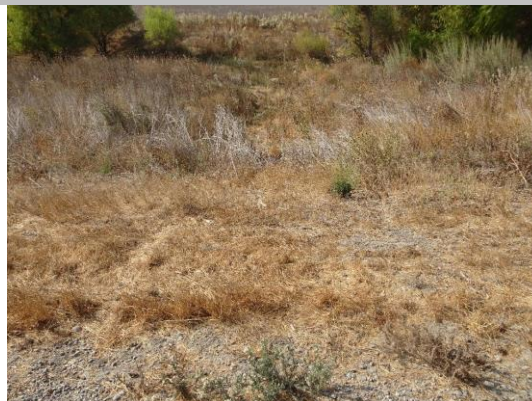
Photo 3 of 3 : UCIP\_FA\_2021\_64794\_90966.jpg

WS view: dense vegetation along WS toe. Pipe and flap gate visible on WS toe.

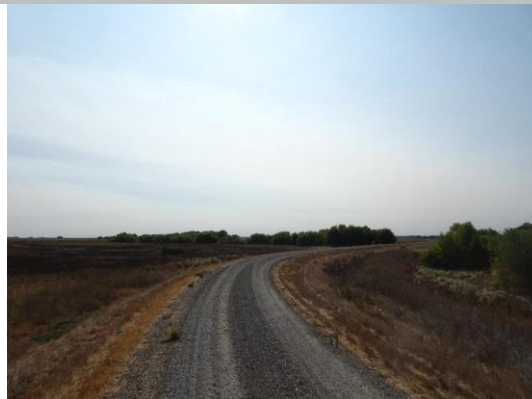
Photo 1 of 3 : UCIP\_FA\_2021\_64795\_92844.jpg

Comment Code					
Inspector Comment					
DS_ID:19638 FS_ID:64795 EP_NO: N/A Repair Type: Non-Urgent EVAL Issue: Unauthorized Encroachment, installed decades prior Crossing Status: Found UCIP Comments: 10/21/2020 Record remains Non-Urgent. No permit was found authorizing this encroachment. CVFPB will need to review crossing to determine owner. DWR DMP internal inspection is pending and scheduled for 2021. (B. Singh - GEI, O. Magana - DWR UCIP)04/25/2014 Dense vegetation limits the inspector's visibility to identify signs of pipe failure (leaks) along the landward slope. Concrete headwall blocked by debris located on landward toe. Recommend clearing debris from landward slope and toe. (O. Magana - DWR UCIP) FIELD_STRUCT_DESC: 24-inch corrugated metal gravity drainage pipe through the levee, 14.2 feet below the crown. Flap gate on the waterside (WS) end. Brass cap No. 60 bench mark (BM) on the headwall on the landside (LS). [Additional Reference(s): DWR Levee Log, 2002 (HLM 13.48), listed as a 24-inch corrugated metal pipe (CMP). USACE San Joaquin O&M Manual, Unit 601 Part 1 (SJR601.1), 1967, Revised 25 May 2011, (HLM 13.48), listed as a 24-inch CMP]. FS Date: 10/21/2020

Overview of levee looking upstream towards pipe.

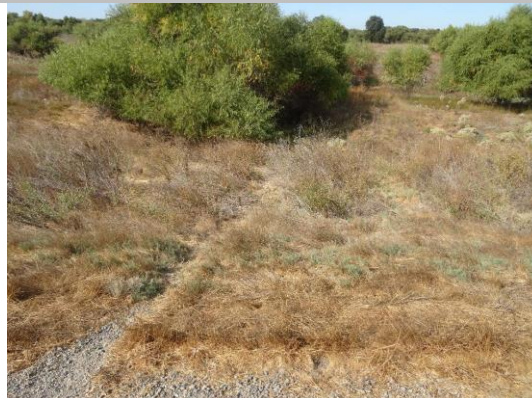
Photo 2 of 3 : UCIP\_FA\_2021\_64795\_90967.jpg

WS view: overview of WS

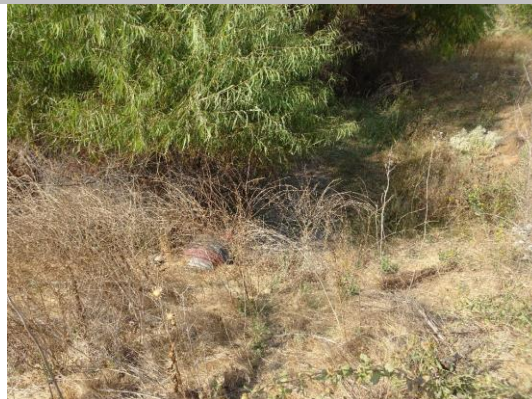
Photo 3 of 3 : UCIP\_FA\_2021\_64795\_90969.jpg

WS view: pipe and flapgate visible at WS toe

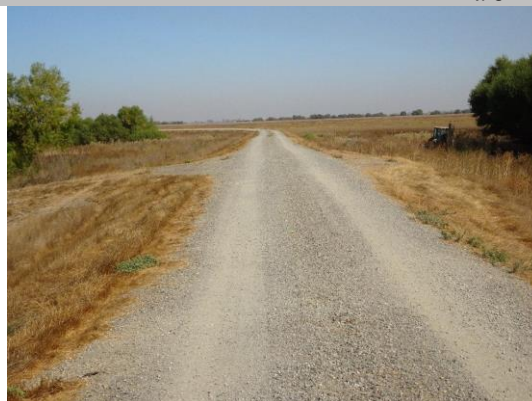
Photo 1 of 3 : UCIP\_FA\_2021\_64796\_90971.jpg

DS\_ID:19639  
FS\_ID:64796  
EP\_NO: N/A  
Repair Type: Non-Urgent  
EVAL Issue: Unauthorized Encroachment, installed decades prior  
Crossing Status: Found  
UCIP Comments: 10/21/2020 Record remains Non-Urgent. No permit was found authorizing this encroachment. CVFPB will need to review crossing to determine owner. DWR DMP internal inspection is pending and scheduled for 2021. (B. Singh - GEI, O. Magana - DWR UCIP)04/25/2014 No access to waterward toe due to fence. Unable to find the concrete headwall and flap gate on waterward side past fence. Also dense vegetation limits the inspector's visibility to identify signs of pipe failure (leaks) along the waterward slope. Recommend removing vegetation along pipe alignment to conduct proper inspection of structure. Also need access past fence on waterward side. (O. Magana - DWR UCIP)  
FIELD\_STRUCT\_DESC: 24-inch corrugated metal gravity drainage pipe through the levee, 14.5 feet below the crown. Flap gate on the waterside (WS) end. Brass cap No. 60 bench mark (BM) on the headwall on the landside (LS). [Additional Reference(s): DWR Levee Log, 2002 (HLM 13.58), listed as a 24-inch corrugated metal pipe (CMP). USACE San Joaquin O&M Manual, Unit 601 Part 1 (SJR601.1), 1967, Revised 25 May 2011, (HLM 13.58), listed as a 24-inch CMP].

Overview of levee crown looking downstream towards crossing.

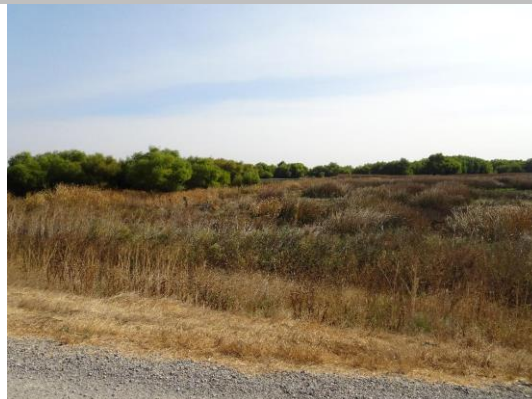
Photo 2 of 3 : UCIP\_FA\_2021\_64796\_90973.jpg

LS view: overview of LS. No headwall found through dense vegetation.

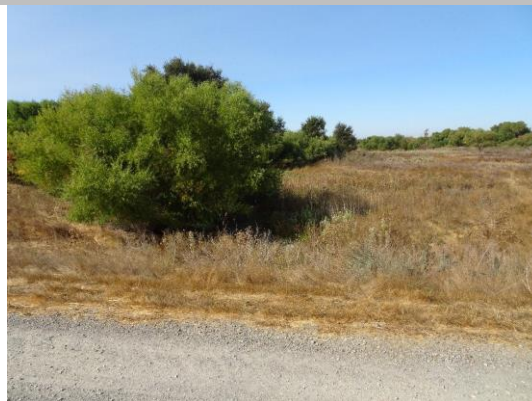
Photo 3 of 3 : UCIP\_FA\_2021\_64796\_90972.jpg

WS view: overview of WS.

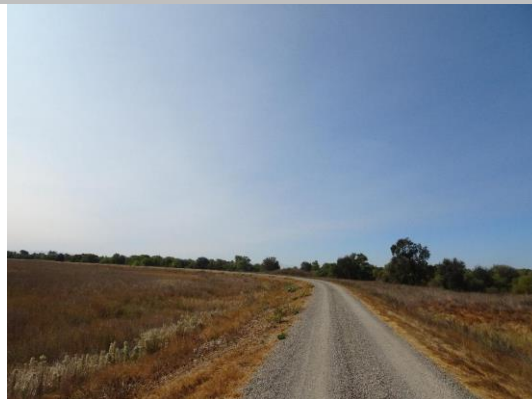
Photo 1 of 3 : UCIP\_FA\_2021\_64797\_90976.jpg

Comment Code					
Inspector Comment					
DS_ID:19640 FS_ID:64797 EP_NO: N/A Repair Type: Non-Urgent EVAL Issue: Unauthorized Encroachment, installed decades prior Crossing Status: Indicator Found UCIP Comments: 10/21/2020 Record remains Non-Urgent. No permit was found authorizing this encroachment. CVFPB will need to review crossing to determine owner. DWR DMP has not found internal issues, LOF between 1 and 2. Recommend inspection in 5 years. (B. Singh - GEI, O. Magana - DWR UCIP)04/25/2014 No photos available-- missed crossing. Aerial photograph indicates crossing is present. Need to confirm if crossing is still present on waterward side. (O. Magana - DWR UCIP) FIELD_STRUCT_DESC: 24-inch corrugated metal gravity drainage pipe through the levee, 11 feet below the crown. Flap gate on the waterside (WS) end. Brass cap No. 60 bench mark (BM) on the headwall on the landside (LS). [Additional Reference(s): DWR Levee Log, 2002 (HLM 13.83), listed as a 24-inch corrugated metal pipe (CMP). USACE San Joaquin O&M Manual, Unit 601 Part 1 (SJR601.1), 1967, Revised 25 May 2011, (HLM 13.81), listed as a 24-inch CMP]. FS Date: 10/21/2020

Overview of levee crown looking upstream towards crossing, photo 1 of 2.

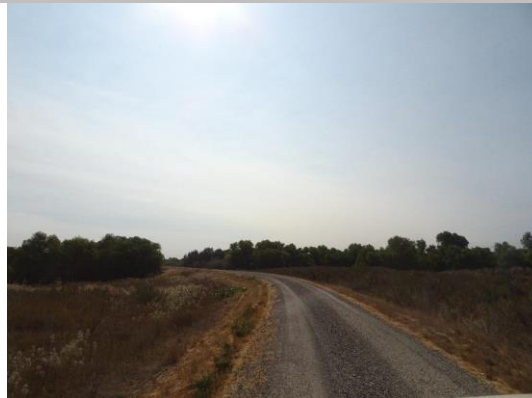
Photo 2 of 3 : UCIP\_FA\_2021\_64797\_92858.jpg

Overview of levee crown looking upstream towards crossing, photo 2 of 2.

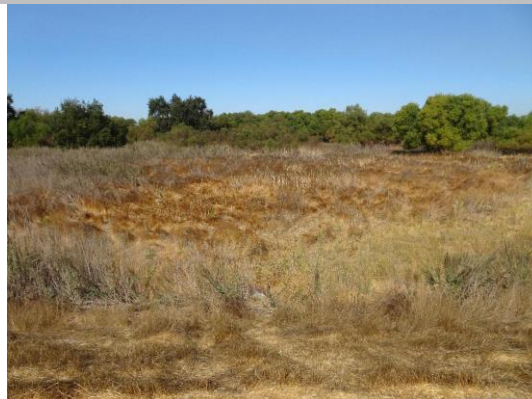
Photo 3 of 3 : UCIP\_FA\_2021\_64797\_90978.jpg

WS view: overview of WS. Pipe and flapgate visible at WS toe

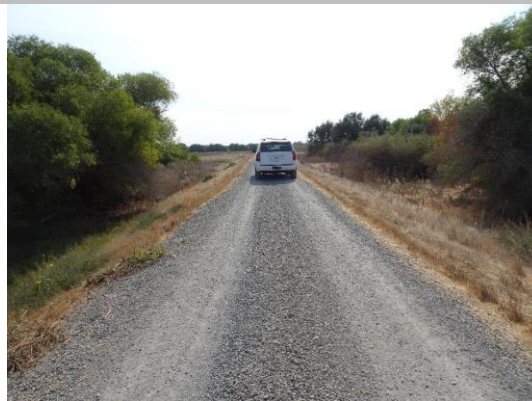
Photo 1 of 3 : UCIP\_FA\_2021\_64799\_90986.jpg

DS\_ID:19641  
 FS\_ID:64799  
 EP\_NO: N/A  
 Repair Type: Non-Urgent  
 EVAL Issue: Limited Inspection/No UCIP Evaluation  
 Crossing Status: Found  
 UCIP Comments: 10/21/2020 Record remains Non-Urgent. Dense vegetation at LS and WS toes inhibited proper inspection. No permit was found authorizing this encroachment. CVFPB will need to review crossing to determine owner. DWR DMP has not found internal issues, LOF between 1 and 2. Recommend inspection in 5 years. (B. Singh - GEI, O. Magana - DWR UCIP)04/25/2014 Dense vegetation limits the inspector's visibility to identify signs of pipe failure (leaks) along the slopes. Recommend removing vegetation along pipe alignment to conduct proper inspection of structure. (O. Magana - DWR UCIP) FIELD\_STRUCT\_DESC: 24-inch corrugated metal gravity drainage pipe through the levee, 13 feet below the crown. Flap gate on the waterside (WS) end. Brass cap No. 60 bench mark (BM) on the headwall on the landside (LS). [Additional Reference(s): DWR Levee Log, 2002 (HLM 14.22), listed as a 24-inch corrugated metal pipe (CMP). USACE San Joaquin O&M Manual, Unit 601 Part 1 (SJR601.1), 1967, Revised 25 May 2011, (HLM 14.21), listed as a 24-inch CMP]. FS Date: 10/21/2020

Overview of levee crown looking upstream towards pipe crossing.

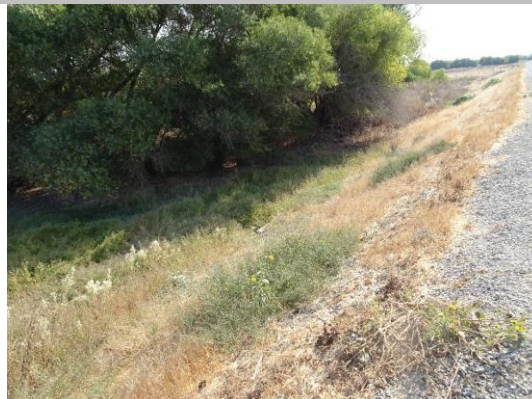
Photo 2 of 3 : UCIP\_FA\_2021\_64799\_90988.jpg

LS view: overview of LS

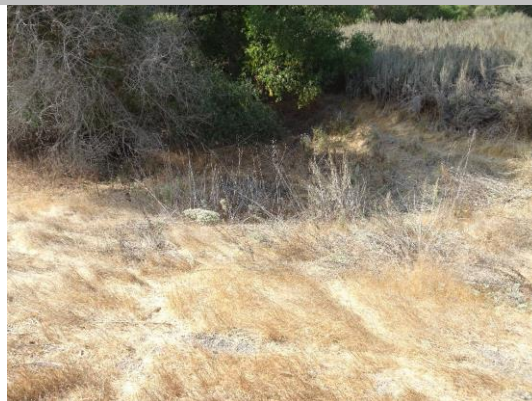
Photo 3 of 3 : UCIP\_FA\_2021\_64799\_90990.jpg

WS view: overview of WS

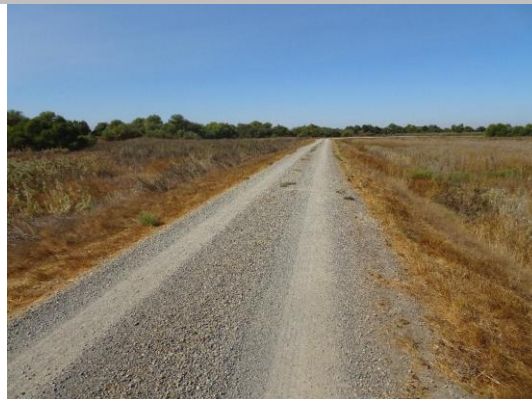
Photo 1 of 3 : UCIP\_FA\_2021\_64864\_90992.jpg

DS\_ID:19642  
FS\_ID:64864  
EP\_NO: N/A  
Repair Type: Non-Urgent  
EVAL Issue: Limited Inspection/No UCIP Evaluation  
Crossing Status: Found  
UCIP Comments: 10/21/2020 Record remains Non-Urgent. Dense vegetation along the pipe alignment prevented proper inspection of the levee and pipe. No permit was found authorizing this encroachment. CVFPB will need to review crossing to determine owner. DWR DMP has not found internal issues, LOF between 1 and 2. Recommend inspection in 5 years. (B. Singh - GEI, O. Magana - DWR UCIP)04/25/2014 Dense vegetation limits the inspector's visibility to identify signs of pipe failure (leaks) along the landward slope and toe. Recommend removing vegetation along pipe alignment to conduct proper inspection of structure. (O. Magana - DWR UCIP)  
FIELD\_STRUCT\_DESC: 24-inch corrugated metal gravity drainage pipe through the levee, 9.7 feet below the crown. Flap gate on the waterside (WS) end. Brass cap No. 60 bench mark (BM) on the headwall on the landside (LS). [Additional Reference(s): DWR Levee Log, 2002 (HLM 14.65), listed as a 24-inch corrugated metal pipe (CMP). USACE San Joaquin O&M Manual, Unit 601 Part 1 (SJR601.1), 1967, Revised 25 May 2011, (HLM 14.65), listed as a 24-inch CMP].

Overview of levee crown looking downstream toward crossing.

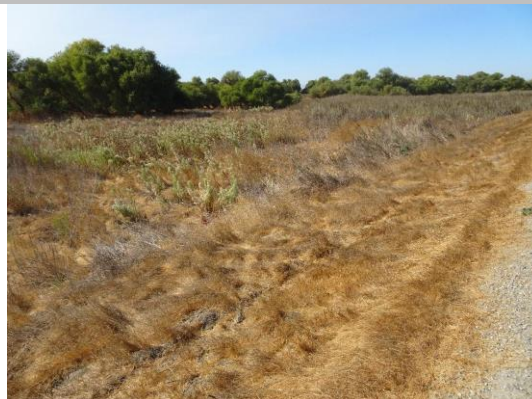
Photo 2 of 3 : UCIP\_FA\_2021\_64864\_90993.jpg

WS view: WS slope profile looking downstream

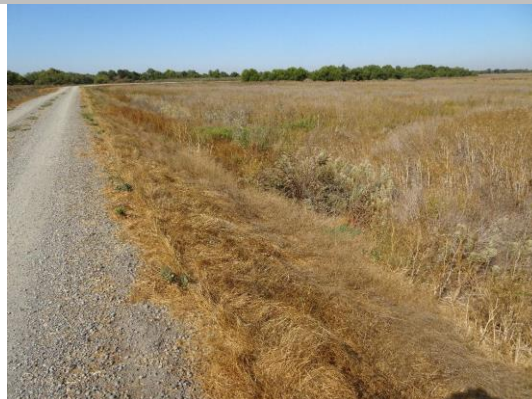
Photo 3 of 3 : UCIP\_FA\_2021\_64864\_90994.jpg

LS view: LS slope profile looking downstream

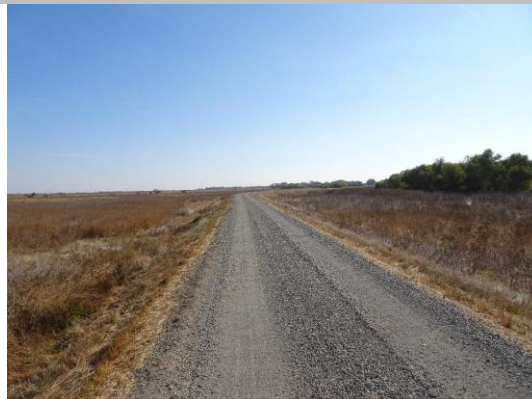
Photo 1 of 3 : UCIP\_FA\_2021\_64801\_90792.jpg

DS\_ID:19643  
 FS\_ID:64801  
 EP\_NO: N/A  
 Repair Type: Non-Urgent  
 EVAL Issue: Limited Inspection/No UCIP Evaluation  
 Crossing Status: Found  
 UCIP Comments: 11/16/2020 Record remains Non-Urgent. Dense vegetation on LS toe limited inspection of pipe. Significant burrowing observed on LS and WS slopes. Recommend vegetation removal and rodent mitigation. No permit was found authorizing this encroachment. CVFPB will need to review crossing to determine owner. DWR DMP has not found internal issues, LOF between 1 and 2. Recommend inspection in 5 years. (B. Singh - GEI, O. Magana - DWR UCIP)04/25/2014 Dense vegetation limits the inspector's visibility to identify signs of pipe failure (leaks) along the landward slope. Recommend removing vegetation along pipe alignment to conduct proper inspection of structure. (O. Magana - DWR UCIP)  
 FIELD\_STRUCT\_DESC: 24-inch corrugated metal gravity drainage pipe through the levee, 9.2 feet below the crown. Flap gate on the waterside (WS) end. Brass cap No. 60 bench mark (BM) on the headwall on the landside (LS). [Additional Reference(s): DWR Levee Log, 2002 (HLM 15.31), listed as a 24-inch corrugated metal pipe (CMP). USACE San Joaquin O&M Manual, Unit 601 Part 1 (SJR601.1), 1967, Revised 25 May 2011, (HLM 15.29), listed as a 24-inch CMP].

Overview of levee crown, looking US

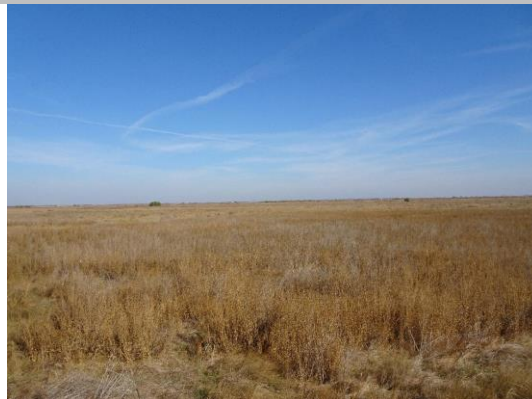
Photo 2 of 3 : UCIP\_FA\_2021\_64801\_92869.jpg

LS view: overview of LS.

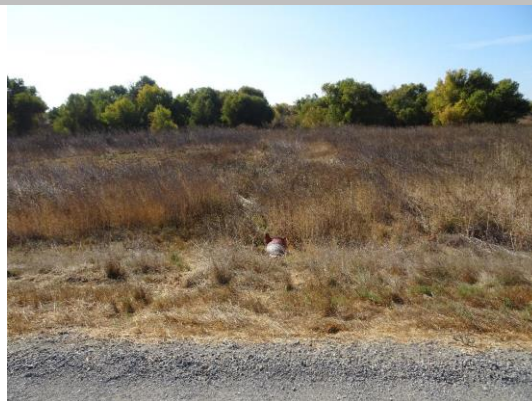
Photo 3 of 3 : UCIP\_FA\_2021\_64801\_90793.jpg

WS view: overview of WS. Pipe and flapgate visible on WS toe.

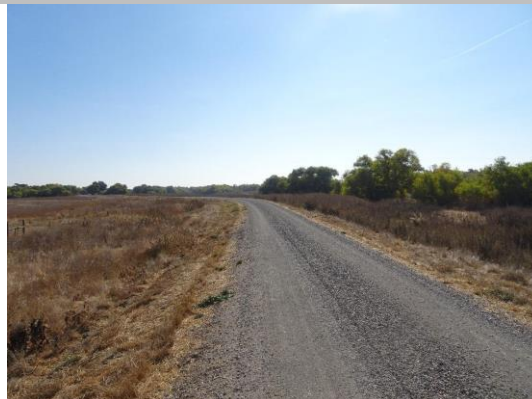
Photo 1 of 3 : UCIP\_FA\_2021\_64802\_90797.jpg

DS\_ID:19644  
FS\_ID:64802  
EP\_NO: N/A  
Repair Type: Non-Urgent  
EVAL Issue: Limited Inspection/No UCIP Evaluation  
Crossing Status: Found  
UCIP Comments: 11/16/2020 Recor remains Non-Urgent. Dense vegetation on LS toe and slope inhibited proper inspection of pipe. No permit was found authorizing this encroachment. CVFPB will need to review crossing to determine owner. DWR DMP has not found internal issues, LOF between 1 and 2. Recommend inspection in 5 years. (O. Magana - DWR UCIP, B. Singh - GEI)04/25/2014 Dense vegetation limits the inspector's visibility to identify signs of pipe failure (leaks) along the waterward and landward slopes. Recommend removing vegetation along pipe alignment to conduct proper inspection of structure. (O. Magana - DWR UCIP)  
FIELD\_STRUCT\_DESC: 24-inch corrugated metal gravity drainage pipe through the levee, 8.5 feet below the crown. Flap gate on the waterside (WS) end. Brass cap No. 60 bench mark (BM) on the headwall on the landside (LS). [Additional Reference(s): DWR Levee Log, 2002 (HLM 15.57), listed as a 24-inch corrugated metal pipe (CMP). USACE San Joaquin O&M Manual, Unit 601 Part 1 (SJR601.1), 1967, Revised 25 May 2011, (HLM 15.57), listed as a 24-inch CMP].

Overview of levee crown, looking US

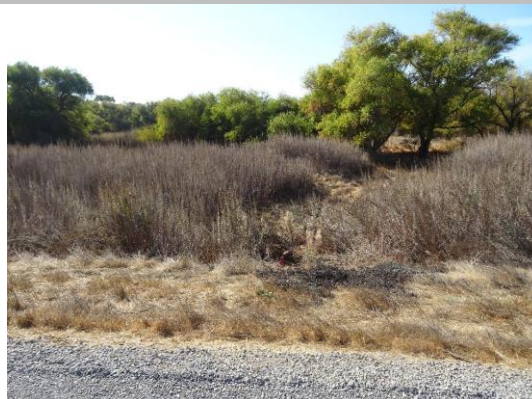
Photo 2 of 3 : UCIP\_FA\_2021\_64802\_90798.jpg

WS view: overview of WS. Pipe and flapgate visible at WS toe.

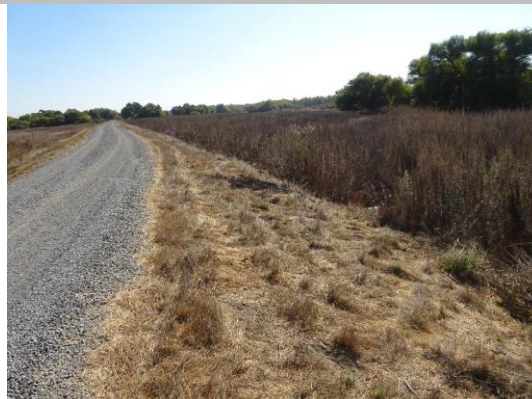
Photo 3 of 3 : UCIP\_FA\_2021\_64802\_92963.jpg

WS view: profile of WS slope.

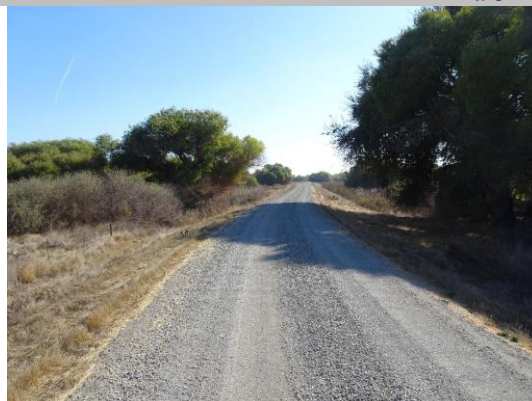
Photo 1 of 3 : UCIP\_FA\_2021\_64865\_90803.jpg

DS\_ID:19645  
 FS\_ID:64865  
 EP\_NO: N/A  
 Repair Type: Non-Urgent  
 EVAL Issue: Unauthorized Encroachment, installed decades prior  
 Crossing Status: Found  
 UCIP Comments: 11/16/2020 Record remains Non-Urgent. Corrosion observed in pipe inlet on the LS toe. Recommend internal inspection of the pipe through the levee to determine extent of damage. Some burrowing activity found on both LS and WS slope. No permit was found authorizing this encroachment. CVFPB will need to review crossing to determine owner. DWR DMP internal inspection is pending and scheduled for 2021. (B. Singh - GEI, O. Magana - DWR UCIP)04/25/2014 Dense vegetation limits the inspector's visibility to identify signs of pipe failure (leaks) along the waterward and landward slope. Recommend removing vegetation along pipe alignment to conduct proper inspection of structure. (O. Magana - DWR UCIP)  
 FIELD\_STRUCT\_DESC: 24-inch corrugated metal gravity drainage pipe through the levee, 11 feet below the crown. Flap gate on the waterside (WS) end. Brass cap No. 60 bench mark (BM) on the headwall on the landside (LS). [Additional Reference(s): DWR Levee Log, 2002 (HLM 15.82), listed as a 24-inch corrugated metal pipe (CMP). USACE San Joaquin O&M Manual, Unit 601 Part 1 (SJR601.1), 1967, Revised 25 May 2011, (HLM 15.81), listed as a 24-inch CMP].

Overview of levee crown, looking US

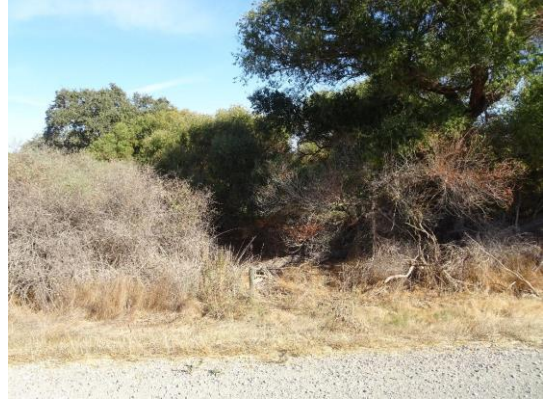
Photo 2 of 3 : UCIP\_FA\_2021\_64865\_90804.jpg

LS view: overview of LS

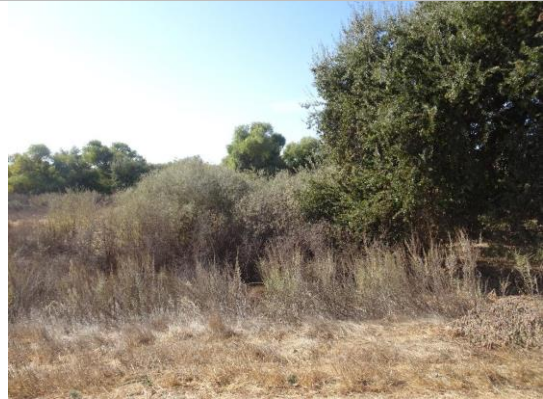
Photo 3 of 3 : UCIP\_FA\_2021\_64865\_90805.jpg

WS view: overview of WS

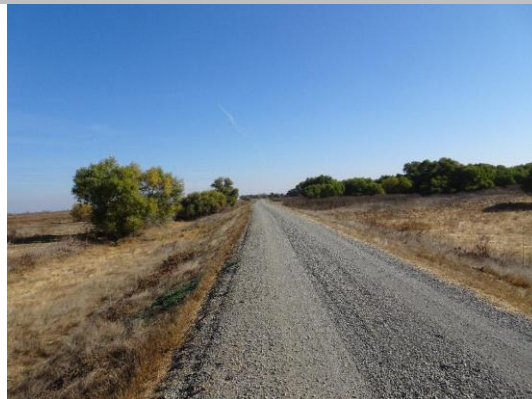
Photo 1 of 3 : UCIP\_FA\_2021\_64804\_92966.jpg

DS\_ID:19646  
FS\_ID:64804  
EP\_NO: N/A  
Repair Type: Urgent  
EVAL Issue: Pipe Integrity  
Crossing Status: Found  
UCIP Comments: 11/16/2020 Record has been updated from Non-Urgent to Urgent. DWR DMP has found integrity issues, LOF between 5 and 6. Crossing will be monitored until funding becomes available to address. Burrowing activity observed on LS and WS slopes. No permit was found authorizing this encroachment. CVFPB will need to review crossing to determine owner. (B. Singh - GEI, O. Magana - DWR UCIP)04/25/2014 Dense vegetation limits the inspector's visibility to identify signs of pipe failure (leaks) along the waterward and landward slopes. Recommend removing vegetation along pipe alignment to conduct proper inspection of structure and appurtenances. (O. Magana - DWR UCIP)  
FIELD\_STRUCT\_DESC: 24-inch corrugated metal gravity drainage pipe through the levee, 11.3 feet below the crown. Flap gate on the waterside (WS) end. Brass cap No. 50 bench mark (BM) on the headwall on the landside (LS). [Additional Reference(s): DWR Levee Log, 2002 (HLM 16.09), listed as a 24-inch corrugated metal pipe (CMP). USACE San Joaquin O&M Manual, Unit 601 Part 1 (SJR601.1), 1967, Revised 25 May 2011, (HLM 16.09), listed as a 24-inch pipe].

Overview of levee looking upstream towards crossing.

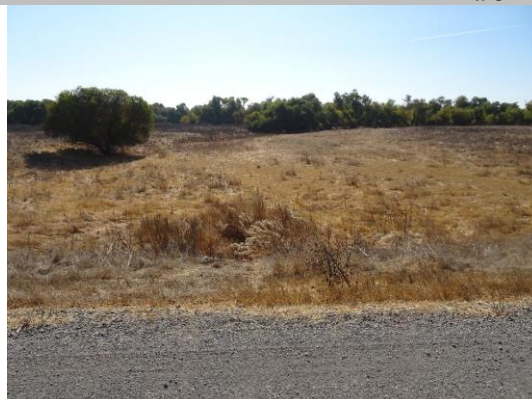
Photo 2 of 3 : UCIP\_FA\_2021\_64804\_92967.jpg

WS view: overview of WS.

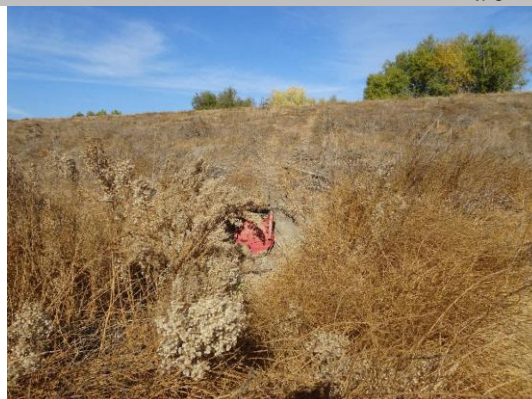
Photo 3 of 3 : UCIP\_FA\_2021\_64804\_92965.jpg

WS view: concrete wingwall and pipe with flap gate visible on WS toe.

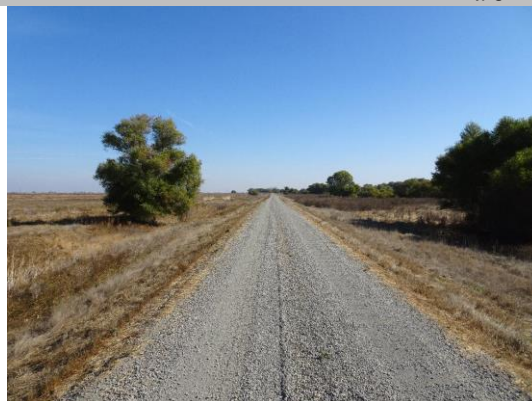
Photo 1 of 3 : UCIP\_FA\_2021\_64866\_92979.jpg

DS\_ID:19647  
 FS\_ID:64866  
 EP\_NO: N/A  
 Repair Type: Non-Urgent  
 EVAL Issue: Limited Inspection/No UCIP Evaluation  
 Crossing Status: Found  
 UCIP Comments: 11/16/2020 Record remains Non-Urgent. Pipe and flapgate on WS toe were under water and there is dense vegetation on the LS slope and toe, inhibiting inspection. No permit was found authorizing this encroachment. CVFPB will need to review crossing to determine owner. DWR DMP internal inspection status is pending. Contacted A. Asrate with DMP staff to find out internal inspection results from 2020. (B. Singh - GEI, O. Magana - DWR UCIP)04/25/2014 Dense vegetation limits the inspector's visibility to identify signs of pipe failure (leaks) along the waterward and landward slopes. Recommend removing vegetation along pipe alignment to conduct proper inspection of structure. Unable to find pipe on landward side. (O. Magana - DWR UCIP)

Overview of levee crown looking upstream towards pipe crossing.

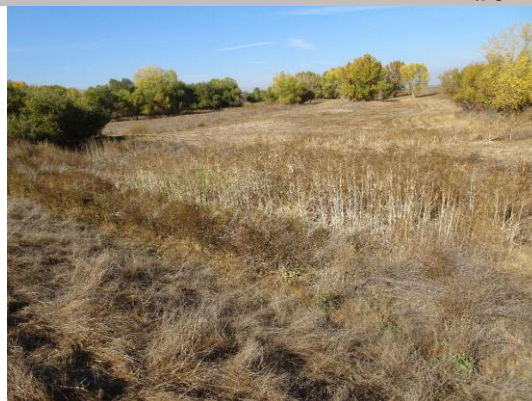
Photo 2 of 3 : UCIP\_FA\_2021\_64866\_92980.jpg

LS view: overview of LS.

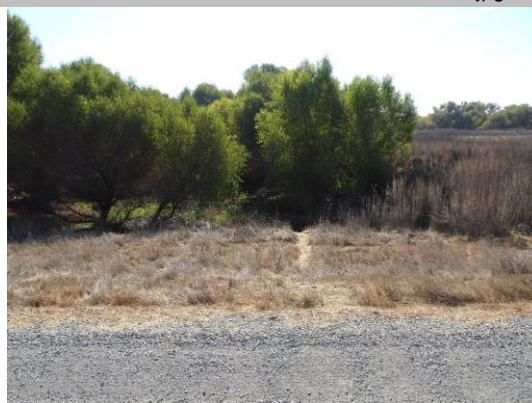
Photo 3 of 3 : UCIP\_FA\_2021\_64866\_92978.jpg

WS view: overview of WS.

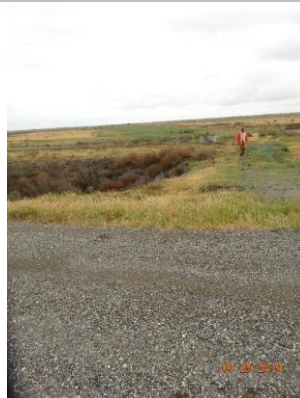
Photo 2 of 2 : UCIP\_FA\_2021\_64834\_71486.jpg

View of landward side.

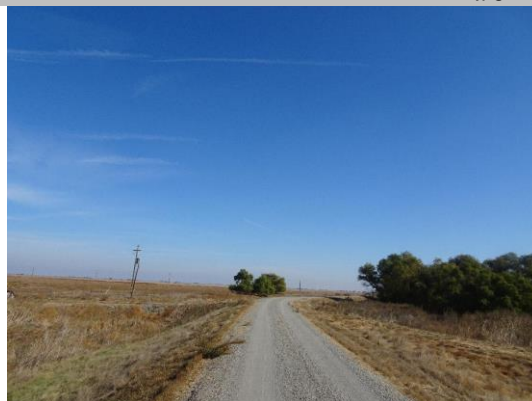
Photo 1 of 3 : UCIP\_FA\_2021\_64867\_90813.jpg

Comment Code					
Inspector Comment					
DS_ID:19649 FS_ID:64867 EP_NO: 13549 Repair Type: Non-Urgent EVAL Issue: Pipe Not Found Crossing Status: Not Found UCIP Comments: 11/16/2020 Record remains Non-Urgent. Gravity drainage pipe through the levee, 2 feet below the crown, was measured at 12 inches instead of 30 inches pipe. Pump and concrete standpipe at the center of the levee were not found, and a siphon breaker was not found on the LS shoulder. Recommend a detail review of permit and record files to determine what was constructed at this location and the alignment of the pipe. Need to contact owner to obtain permit authorizing modifications to previously approved 30-inch pipe. (B. Singh - GEI, O. Magana - DWR UCIP) FIELD_STRUCT_DESC: 30-inch coated steel gravity drainage pipe through the levee, 2 feet below the crown. Steel cutoff walls at the center of the levee. Siphon breaker on the apex of the pipe on the landside (LS) shoulder. Pump and concrete standpipe on the waterside (WS). Extends to existing irrigation ditch off the LS toe. (Plans to construct a concrete irrigation pipe stand, to install a 60-horsepower pump with a 30-inch steel discharge pipeline through the levee, and to enlarge the diversion channel from the river to the pump intake authorized under Permit No. 13549, 1983 - Joseph E. Gallo). [Additional Reference(s): DWR Levee Log, 2002 (HLM 16.73), listed as a 30-inch steel pipe]. FS Date: 11/16/2020

Overview of levee crown, looking US

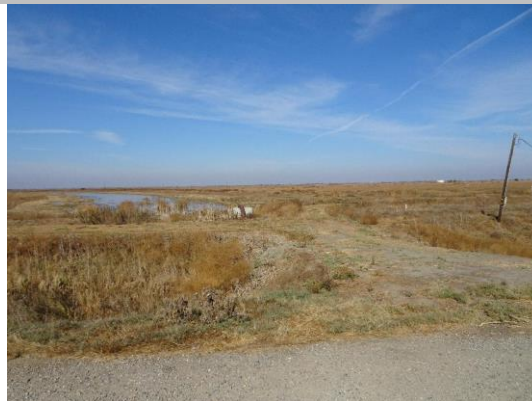
Photo 3 of 3 : UCIP\_FA\_2021\_64867\_90815.jpg

LS view: overview of LS. Concrete cone with 12" pipe found.

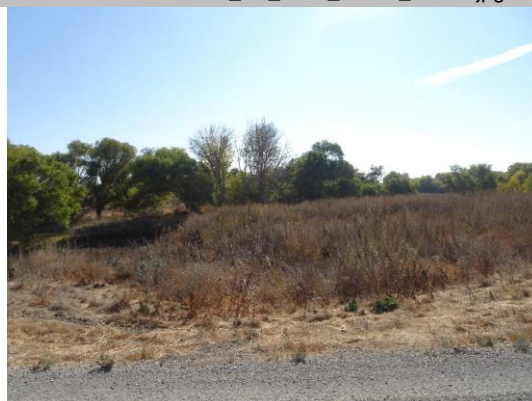
Photo 2 of 3 : UCIP\_FA\_2021\_64806\_90821.jpg

DS\_ID:19648  
FS\_ID:64806  
EP\_NO: N/A  
Repair Type: Non-Urgent  
EVAL Issue: Limited Inspection/No UCIP Evaluation  
Crossing Status: Found  
UCIP Comments: 11/16/2020 Record remains Non-Urgent. Unable to locate pipe on both LS and WS toes due to dense vegetation. Recommend vegetation removal for proper inspections. DWR DMP internal inspection is pending and scheduled for 2021. No permit was found authorizing this encroachment. CVFPB will need to review crossing to determine owner. (B. Singh - GEI, O. Magana - DWR UCIP)04/25/2014 Dense vegetation limits the inspector's visibility to identify signs of pipe failure (leaks) along the waterward and landward slopes. Recommend removing vegetation along pipe alignment to conduct proper inspection of structure. Unable to find pipe on landward side. (O. Magana - DWR UCIP)  
FIELD\_STRUCT\_DESC: 24-inch corrugated metal gravity drainage pipe through the levee, 11.4 feet below the crown. Flap gate on the waterside (WS) end. Brass cap No. 50 bench mark (BM) on the headwall on the landside (LS). [Additional Reference(s): DWR Levee Log, 2002 (HLM 16.73), listed as a 24-inch corrugated metal pipe (CMP). USACE San Joaquin O&M Manual, Unit 601 Part 1 (SJR601.1), 1967, Revised 25 May 2011, (HLM 16.72), listed as a 24-inch CMP].

WS view: overview of WS. Pipe and flapgate not found; dense vegetation.

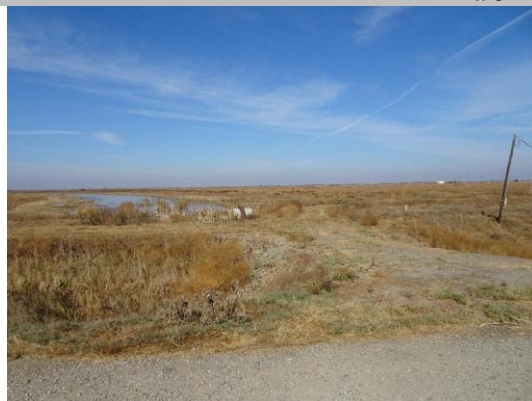
Photo 3 of 3 : UCIP\_FA\_2021\_64806\_90824.jpg

LS view: overview of LS.
