## Flood Control Project Maintenance Levee Inspections

### Fall 2021 Levee Maintenance Deficiency Summary Report

#### San Joaquin River Basin

NA0010 Lower San Joaquin Levee District	Overall LMA Rating	Total LMA Miles							
	U	191.27							
Rated Item	Maintenance Deficiency				Enforcement		Design & System Obsolescence		
	M Miles	U Miles	M + 4U Miles	Threshold %	M Miles	U Miles	M Miles	U Miles	
<i>Earthen Levee</i>									
Vegetation	47.00	9.57	85.28	44.59%					
Trim / Thin Trees	0.10		0.10	0.05%					
Encroachments	0.23	0.02	0.31	0.16%	9.29	0.59			
Animal Control	7.67	2.19	16.43	8.59%					
Slope Stability	0.05	0.01	0.09	0.05%					
Erosion / Bank Caving	0.13	0.81	3.37	1.76%					
Crown Surface / Depressions / Rutting	0.01		0.01	0.01%					
Repair Gates	0.02	0.02	0.10	0.05%					
<i>Rivers, Channels &amp; Designated Floodways</i>									
Encroachments					0.01	0.01			
<i>Supplemental</i>									
DWR Erosion Survey	0.12	0.17	0.80	0.42%					
DWR UCIP Field Study					1.29	0.05			
DWR UCIP LMA Responsibility									
<i>LMA Totals:</i>	55.33	12.79	106.49	55.67%	10.59	0.65	0.00	0.00

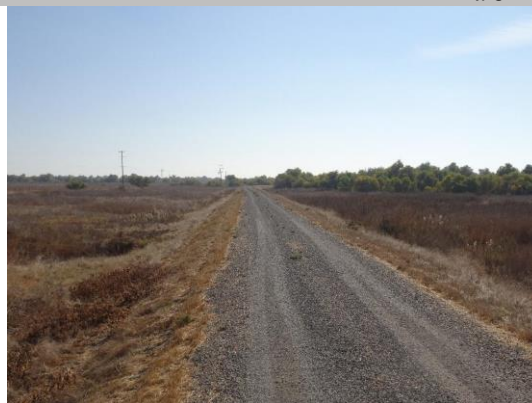
Photo 1 of 3 : UCIP\_FA\_2021\_64807\_90825.jpg

DS\_ID:19577  
 FS\_ID:64807  
 EP\_NO: N/A  
 Repair Type: Non-Urgent  
 EVAL Issue: Unauthorized Encroachment, installed decades prior  
 Crossing Status: Found  
 UCIP Comments: 11/16/2020 Record remains Non-Urgent. No permit was found authorizing this encroachment. CVFPB will need to review crossing to determine owner. DWR DMP has not found internal issues, LOF between 1 and 2. Recommend inspection in 5 years. (B. Singh - GEI, O. Magana - DWR UCIP)04/25/2014 Dense vegetation limits the inspector's visibility to identify signs of pipe failure (leaks) along the waterward and landward slopes. Concrete headwall is buried by dense vegetation. Recommend removing vegetation along pipe alignment to conduct proper inspection of structure. (O. Magana - DWR UCIP)  
 FIELD\_STRUCT\_DESC: 24-inch corrugated metal gravity drainage pipe through the levee, 11.5 feet below the crown. Flap gate on the waterside (WS) end. Brass cap No. 50 bench mark (BM) on the headwall on the landside (LS). [Additional Reference(s): DWR Levee Log, 2002 (HLM 17.01), listed as a 24-inch corrugated metal pipe (CMP). USACE San Joaquin O&M Manual, Unit 601 Part 1 (SJR601.1), 1967, Revised 25 May 2011, (HLM 17.01), listed as a 24-inch CMP].

Overview of levee crown, looking US

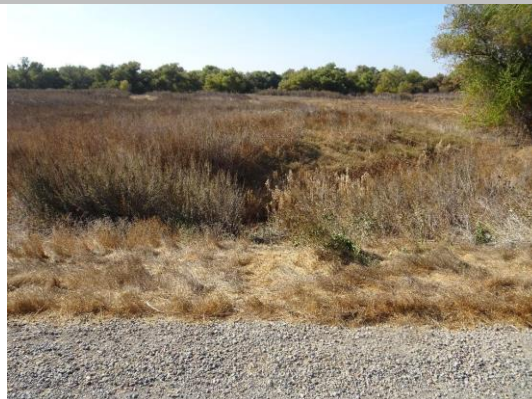
Photo 2 of 3 : UCIP\_FA\_2021\_64807\_92993.jpg

WS view: overview of WS.

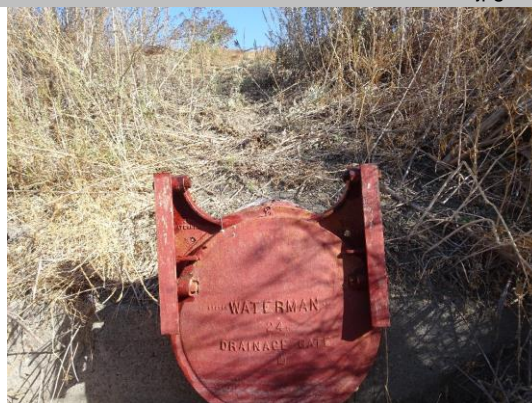
Photo 3 of 3 : UCIP\_FA\_2021\_64807\_92991.jpg

WS view: pipe and flap gate visible on WS toe.

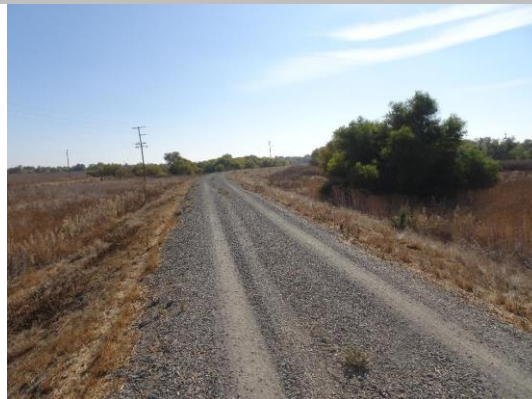
Photo 1 of 3 : UCIP\_FA\_2021\_64808\_93002.jpg

DS\_ID:19578  
FS\_ID:64808  
EP\_NO: N/A  
Repair Type: Non-Urgent  
EVAL Issue: Unauthorized Encroachment, installed decades prior  
Crossing Status: Found  
UCIP Comments: 11/16/2020 Record remains Non-Urgent. No permit was found authorizing this encroachment. CVFPB will need to review crossing to determine owner. DWR DMP has not found internal issues, LOF between 1 and 2. Recommend inspection in 5 years. (B. Singh - GEI, O. Magana - DWR UCIP)04/25/2014 Dense vegetation limits the inspector's visibility to identify signs of pipe failure (leaks) along the waterward and landward slopes. Recommend removing vegetation along pipe alignment to conduct proper inspection of structure. Sediment buildup inside pipe visible from landward side. Recommend clearing pipe. (O. Magana - DWR UCIP)  
FIELD\_STRUCT\_DESC: 24-inch corrugated metal gravity drainage pipe through the levee, 11.5 feet below the crown. Flap gate on the waterside (WS) end. Brass cap No. 50 bench mark (BM) on the headwall on the landside (LS). [Additional Reference(s): DWR Levee Log, 2002 (HLM 17.20), listed as a 24-inch corrugated metal pipe (CMP). USACE San Joaquin O&M Manual, Unit 601 Part 1 (SJR601.1), 1967, Revised 25 May 2011, (HLM 17.19), listed as a 24-inch CMP].

Overview of levee crown looking upstream towards pipe crossing.

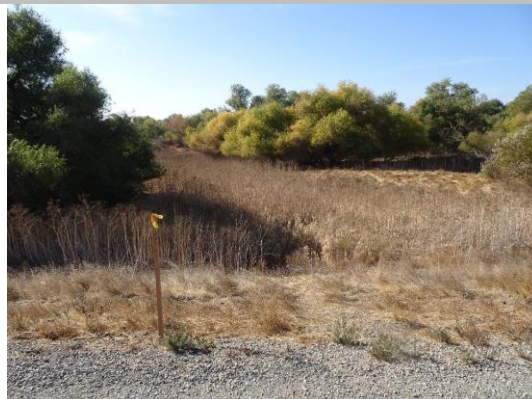
Photo 2 of 3 : UCIP\_FA\_2021\_64808\_93003.jpg

WS view: overview of WS.

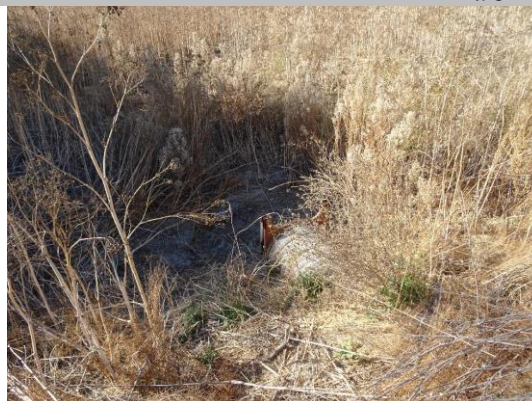
Photo 3 of 3 : UCIP\_FA\_2021\_64808\_93000.jpg

WS view: pipe outlet visible on WS toe.

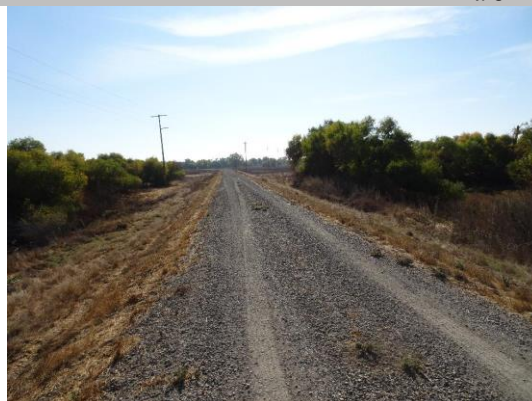
Photo 1 of 3 : UCIP\_FA\_2021\_64809\_90834.jpg

DS\_ID:19579  
FS\_ID:64809  
EP\_NO: N/A  
Repair Type: Non-Urgent  
EVAL Issue: Limited Inspection/No UCIP Evaluation  
Crossing Status: Found  
UCIP Comments: 11/16/2020 Record remains Non-Urgent. Debris is blocking flapgate on the WS inlet. No permit was found authorizing this encroachment. CVFPB will need to review crossing to determine owner. DWR DMP internal inspection is pending and scheduled for 2021. (B. Singh - GEI, O. Magana - DWR UCIP)04/25/2014 Dense vegetation limits the inspector's visibility to identify signs of pipe failure (leaks) along the waterward and landward slope. Recommend removing vegetation along pipe alignment to conduct proper inspection of structure. (O. Magana - DWR UCIP)  
FIELD\_STRUCT\_DESC: 24-inch corrugated metal gravity drainage pipe through the levee, 15.8 feet below the crown. Flap gate on the waterside (WS) end. Brass cap No. 50 bench mark (BM) on the headwall on the landside (LS). [Additional Reference(s): DWR Levee Log, 2002 (HLM 17.27), listed as a 24-inch corrugated metal pipe (CMP). USACE San Joaquin O&M Manual, Unit 601 Part 1 (SJR601.1), 1967, Revised 25 May 2011, (HLM 17.26), listed as a 24-inch CMP].

Overview of levee crown looking upstream towards crossing.

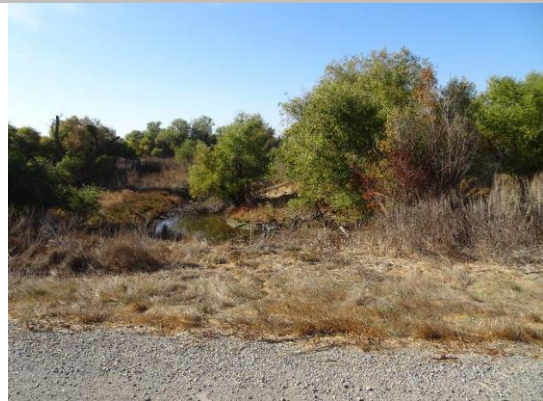
Photo 3 of 3 : UCIP\_FA\_2021\_64809\_90836.jpg

WS view: overview of WS, photo 1 of 2.

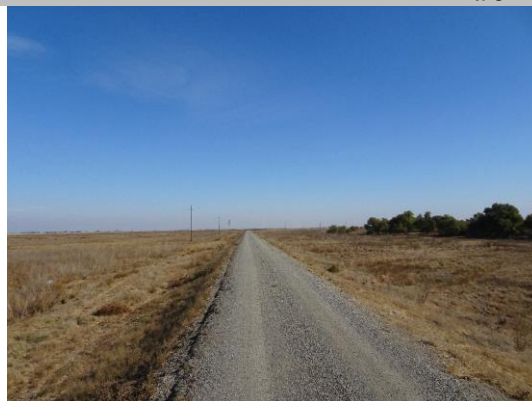
Photo 1 of 3 : UCIP\_FA\_2021\_64868\_90843.jpg

DS\_ID:19580  
FS\_ID:64868  
EP\_NO: N/A  
Repair Type: Urgent  
EVAL Issue: Pipe Integrity  
Crossing Status: Found  
UCIP Comments: 11/16/2020 Record has been updated from Non-Urgent to Urgent. Pipe in failed condition on the LS. Potential sink hole located about 1 foot from the LS toe. No permit was found authorizing this encroachment. CVFPB will need to review crossing to determine owner. DWR DMP internal inspection is pending and scheduled for 2021. (B. Singh - GEI, O. Magana - DWR UCIP)04/25/2014 Dense vegetation limits the inspector's visibility to identify signs of pipe failure (leaks) along the landward slope. Recommend removing vegetation along pipe alignment to conduct proper inspection of structure. (O. Magana - DWR UCIP)  
FIELD\_STRUCT\_DESC: 24-inch corrugated metal gravity drainage pipe through the levee, 9.5 feet below the crown. Flap gate on the waterside (WS) end. Brass cap No. 50 bench mark (BM) on the headwall on the landside (LS). [Additional Reference(s): DWR Levee Log, 2002 (HLM 17.53), listed as a 24-inch corrugated metal pipe (CMP). USACE San Joaquin O&M Manual, Unit 601 Part 1 (SJR601.1), 1967, Revised 25 May 2011, (HLM 17.53), listed as a 24-inch CMP].

Overview of levee crown, looking US

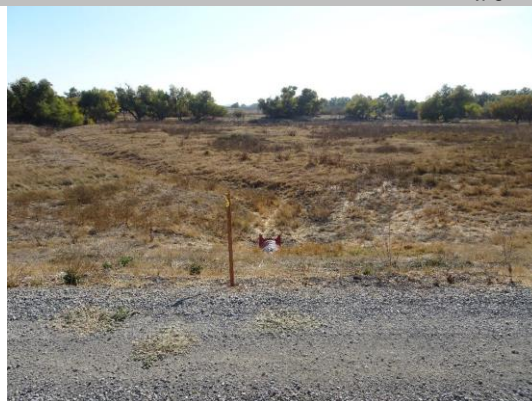
Photo 2 of 3 : UCIP\_FA\_2021\_64868\_90844.jpg

WS view: overview of WS. Pipe and flapgate visible on WS toe.

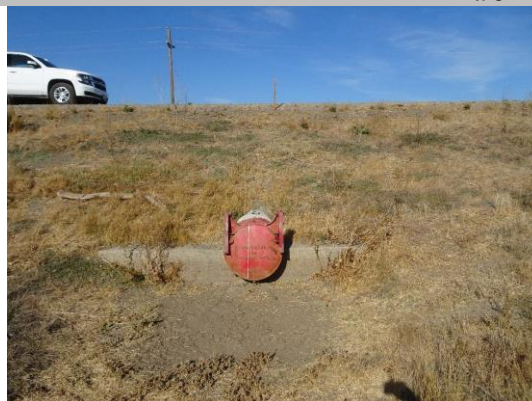
Photo 3 of 3 : UCIP\_FA\_2021\_64868\_90842.jpg

WS view: Pipe, headwall, and flapgate at WS toe.

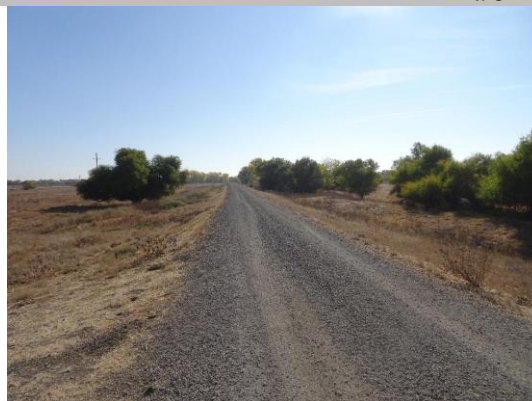
Photo 1 of 3 : UCIP\_FA\_2021\_64811\_90849.jpg

DS\_ID:19581  
 FS\_ID:64811  
 EP\_NO: N/A  
 Repair Type: Urgent  
 EVAL Issue: Pipe Integrity  
 Crossing Status: Found  
 UCIP Comments: 11/16/2020 Record has been updated from Non-Urgent to Urgent. Considerable damage to the pipe interior is visible from LS toe. DWR DMP has found integrity issues, LOF between 5 and 6. Crossing will be monitored until funding becomes available to address. No permit was found authorizing this encroachment. CVFPB will need to review crossing to determine owner. (B. Singh - GEI, O. Magana - DWR UCIP)04/25/2014 Need to contact owner. Recommend investigating integrity of pipe wall through levee heavy corrosion visible from landward side. (O. Magana - DWR UCIP)  
 FIELD\_STRUCT\_DESC: 24-inch corrugated metal gravity drainage pipe through the levee, 11.5 feet below the crown. Flap gate on the waterside (WS) end. Brass cap No. 50 bench mark (BM) on the headwall on the landside (LS). [Additional Reference(s): DWR Levee Log, 2002 (HLM 18.21), listed as a 24-inch corrugated metal pipe (CMP). USACE San Joaquin O&M Manual, Unit 601 Part 1 (SJR601.1), 1967, Revised 25 May 2011, (HLM 18.19), listed as a 24-inch CMP].

Overview of levee crown looking upstream, photo 1 of 2.

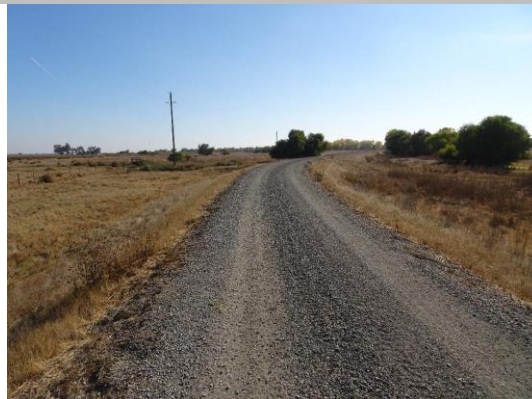
Photo 2 of 3 : UCIP\_FA\_2021\_64811\_93033.jpg

Overview of levee crown looking upstream, photo 2 of 2.

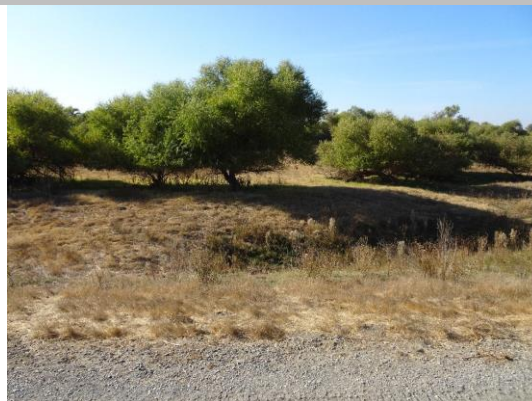
Photo 3 of 3 : UCIP\_FA\_2021\_64811\_90852.jpg

WS view: overview of WS.

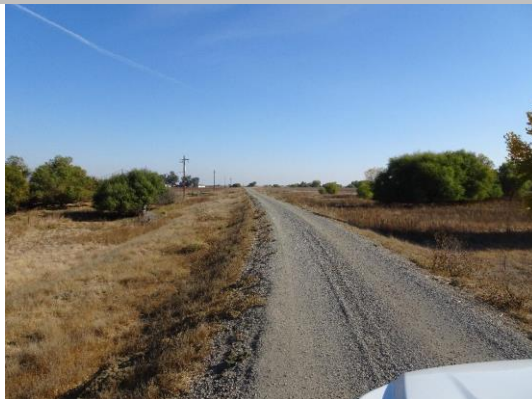
Photo 1 of 3 : UCIP\_FA\_2021\_64812\_93037.jpg

Comment Code						
Inspector Comment						
DS_ID:19582						
FS_ID:64812						
EP_NO: N/A						
Repair Type: Urgent						
EVAL Issue: Pipe Integrity						
Crossing Status: Found						
UCIP Comments: 11/16/2020 Record has been updated from No Action Needed to Urgent. DWR DMP has found integrity issues, LOF between 5 and 6. No damage observed on the levee during the field inspection. Crossing will be monitored until funding becomes available to address. No permit was found authorizing this encroachment. CVFPB will need to review crossing to determine owner. (B. Singh - GEI, O. Magana - DWR UCIP)						
FIELD_STRUCT_DESC: 24-inch corrugated metal gravity drainage pipe through the levee, 9.4 feet below the crown. Flap gate on the waterside (WS) end. Brass cap No. 50 bench mark (BM) on the headwall on the landside (LS). [Additional Reference(s): DWR Levee Log, 2002 (HLM 18.47), listed as a 24-inch corrugated metal pipe (CMP). USACE San Joaquin O&M Manual, Unit 601 Part 1 (SJR601.1), 1967, Revised 25 May 2011, (HLM 18.45), listed as a 24-inch CMP].

Overview of levee crown looking upstream, photo 1 of 2.

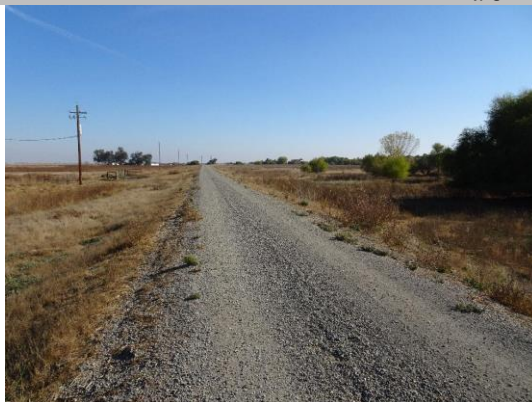
Photo 2 of 3 : UCIP\_FA\_2021\_64812\_90856.jpg

Overview of levee crown looking upstream, photo 2 of 2.

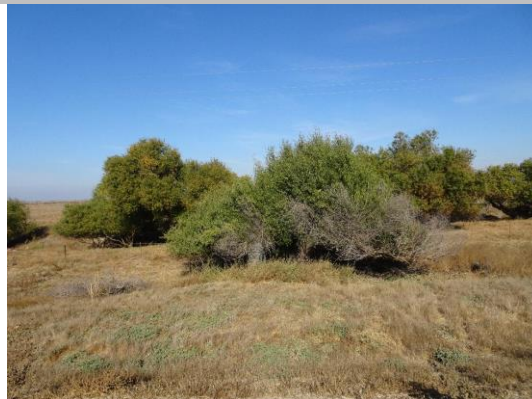
Photo 3 of 3 : UCIP\_FA\_2021\_64812\_90854.jpg

LS view: overview of LS.

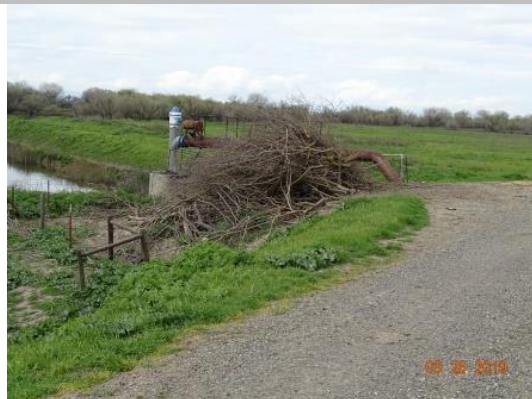
Photo 1 of 1 : FA\_2021\_NA0010\_118\_134\_20210830\_00022.jpg

LM Start	18.77	Rating **	U	Issue No.	134
LM End	18.77	Issue Type +	En	Location *	WS
Category	Earthen Levee			GPS Latitude/Longitude	
				Start	End
Item	Encroachments			37.205064 °	37.205064 °
				-120.762721 °	-120.762721 °
DWR ID	DWR_NA0010_01_s_2019_134				
Comment Code					
PR : Prunings					
Inspector Comment

View of prunings on waterside slope. (Spring 2019)

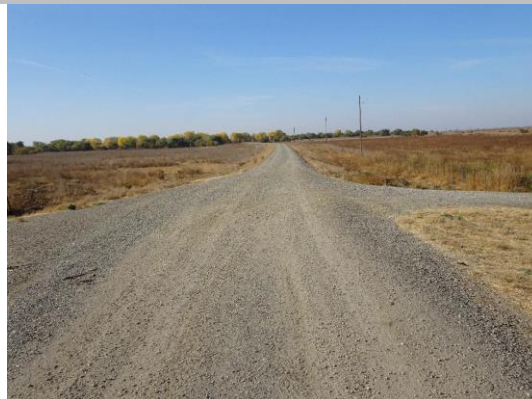
Photo 1 of 3 : UCIP\_FA\_2021\_64871\_91059.jpg

DS\_ID:19593  
FS\_ID:64871  
EP\_NO: N/A  
Repair Type: Non-Urgent  
EVAL Issue: Pipe Damage  
Crossing Status: Found  
UCIP Comments: 11/16/2020 Record remains Non-Urgent. DWR DMP has found integrity issues, LOF between 4 and 5. Crossing will be monitored until funding becomes available for rehabilitation. No permit was found authorizing this encroachment. CVFPB will need to review crossing to determine owner. Fence located on the WS prevented access to the pipe. (B. Singh - GEI, O. Magana - DWR UCIP)04/25/2014 Dense vegetation limits the inspector's visibility to identify signs of pipe failure (leaks) along the landward slope. Recommend removing vegetation along pipe alignment to conduct proper inspection of structure. (O. Magana - DWR UCIP)  
FIELD\_STRUCT\_DESC: 24-inch corrugated metal gravity drainage pipe through the levee, 12 feet below the crown. Flap gate on the waterside (WS) end. Brass cap No. 50 bench mark (BM) on the headwall on the landside (LS). [Additional Reference(s): DWR Levee Log, 2002 (HLM 18.80), listed as a 24-inch corrugated metal pipe (CMP). USACE San Joaquin O&M Manual, Unit 601 Part 1 (SJR601.1), 1967, Revised 25 May 2011, (HLM 18.79), listed as a 24-inch CMP].

Overview of levee crown

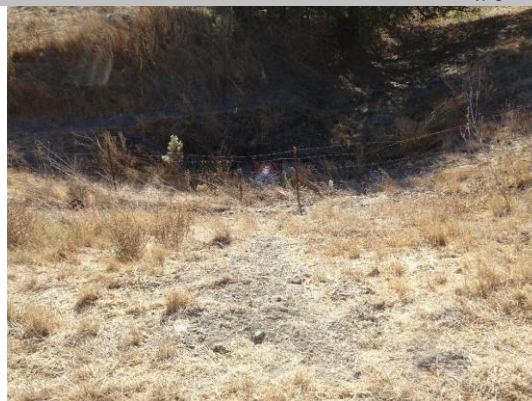
Photo 2 of 3 : UCIP\_FA\_2021\_64871\_91061.jpg

View waterward

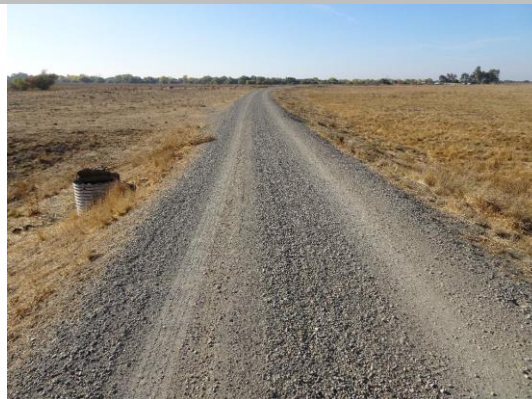
Photo 1 of 3 : UCIP\_FA\_2021\_64873\_90861.jpg

DS\_ID:19594  
FS\_ID:64873  
EP\_NO: N/A  
Repair Type: Non-Urgent  
EVAL Issue: Maintenance Compliance Issue  
Crossing Status: Found  
UCIP Comments: 11/16/2020 Record remains Non-Urgent. Unable to locate pipe on the WS. Pipe appears to be buried on WS. Sediment build-up observed at the LS inlet. Recommend sediment removal and evaluation of pipe's purpose. Pipe is currently non-functional. No permit was found authorizing this encroachment. CVFPB will need to review crossing to determine owner. DWR DMP internal inspection is pending and scheduled for 2021. Recommend adding riser cover on the WS as a safety measure. (B. Singh - GEI, O. Magana - DWR UCIP)04/25/2014 Non-functional crossing--pipe is buried on waterward side. Sediment buildup in pipe visible from landward side. Need to coordinate with owner to determine status. If crossing is no longer in use, owner will need to coordinate with DWR Inspector and CVFPB to properly abandon. (O. Magana - DWR UCIP)

Overview of levee crown

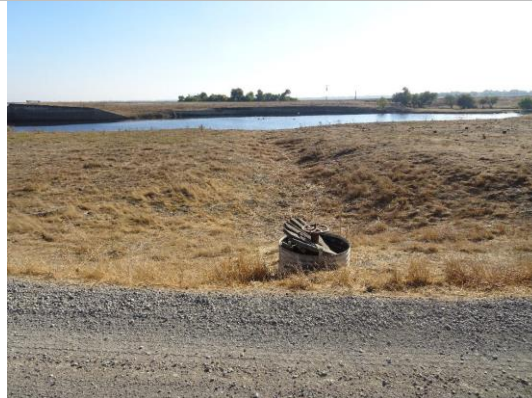
Photo 2 of 3 : UCIP\_FA\_2021\_64873\_90862.jpg

Pipe riser visible on WS slope

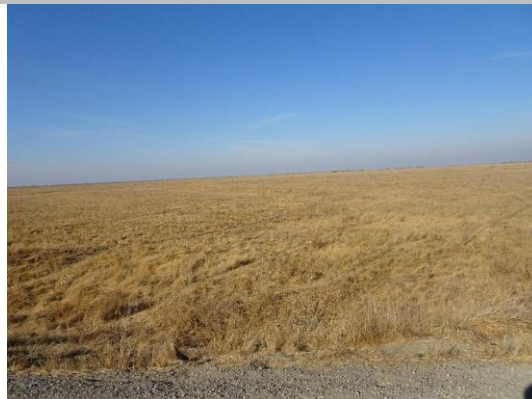
Photo 3 of 3 : UCIP\_FA\_2021\_64873\_90863.jpg

View landward

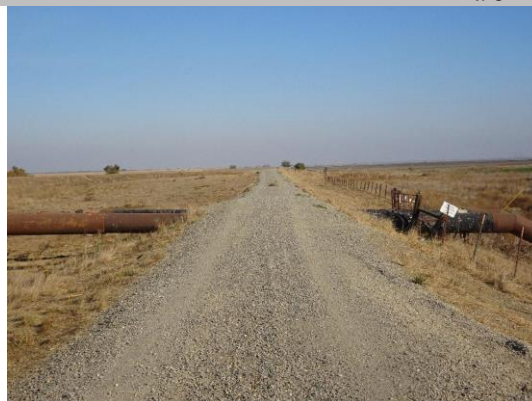
Photo 1 of 3 : UCIP\_FA\_2021\_64874\_90875.jpg

DS\_ID:24871  
 FS\_ID:64874  
 EP\_NO: N/A  
 Repair Type: Non-Urgent  
 EVAL Issue: Unauthorized Encroachment  
 Crossing Status: Found  
 UCIP Comments: 11/16/2020 Record remains Non-Urgent. No permit was found authorizing this encroachment. CVFPB will need to review crossing to determine owner. Pipe measured 24 inches in diameter on the LS end and 20 inches on the WS inlet. (B. Singh - GEI, O. Magana - DWR UCIP)04/25/2014 New crossing found during field inspection--Need to contact owner to obtain additional information about crossing. (O. Magana - DWR UCIP)  
 FIELD\_STRUCT\_DESC: 1 of 2: 20-inch steel drainage discharge pipe through the levee, at an unknown depth. Pump station and electrical panel on the landside (LS). This pipe was field discovered.  
 FS Date: 11/16/2020

Overview of levee crown

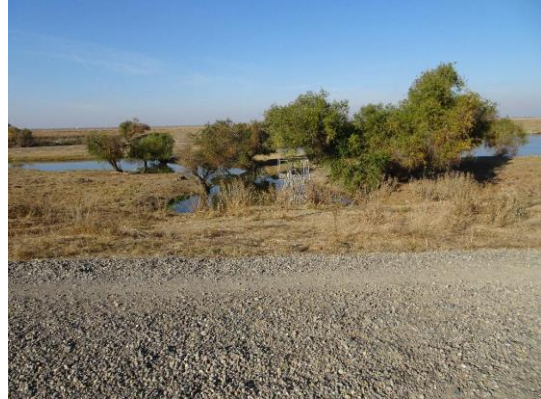
Photo 2 of 3 : UCIP\_FA\_2021\_64874\_90867.jpg

WS view: overview of WS

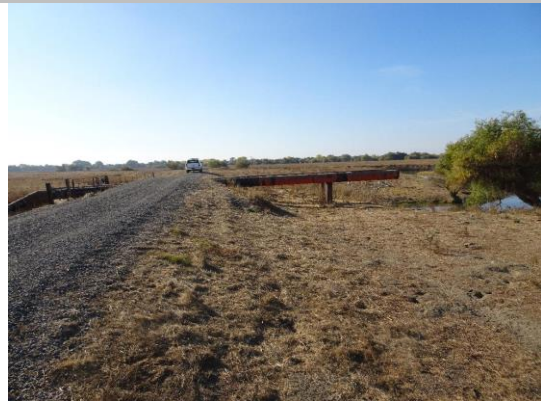
Photo 3 of 3 : UCIP\_FA\_2021\_64874\_90871.jpg

LS view: overview of LS

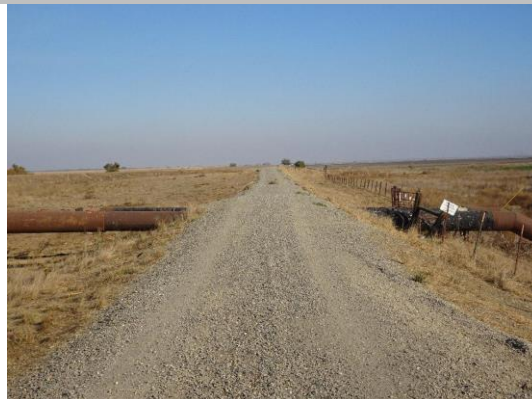
Photo 1 of 3 : UCIP\_FA\_2021\_64875\_90879.jpg

Comment Code					
Inspector Comment					
DS_ID:24872 FS_ID:64875 EP_NO: N/A Repair Type: Non-Urgent EVAL Issue: Unauthorized Encroachment Crossing Status: Found UCIP Comments: 11/16/2020 Record remains Non-Urgent. No permit was found authorizing this encroachment. CVFPB will need to review crossing to determine owner. Pipe measured as 24 inches in diameter at LS outlet. Field structure was updated with updated diameter information. (B. Singh - GEI, O. Magana - DWR UCIP)04/25/2014 New crossing found during field inspection--Need to contact owner to obtain additional information about crossing. (O. Magana - DWR UCIP) FIELD_STRUCT_DESC: 2 of 2: 24-inch steel drainage discharge pipe through the levee, at an unknown depth. Pump station and electrical panel on the landside (LS). This pipe was field discovered. FS Date: 11/16/2020

Overview of levee crown looking d/s

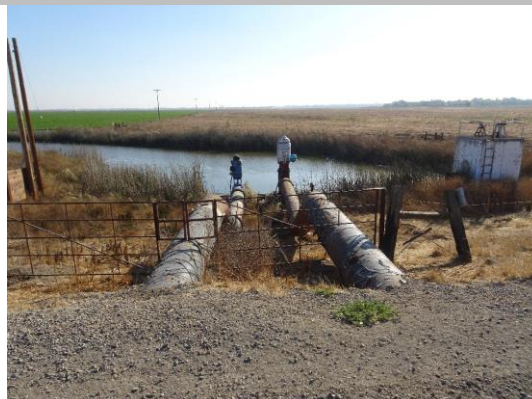
Photo 2 of 3 : UCIP\_FA\_2021\_64875\_90880.jpg

WS view: pipes visible on LS

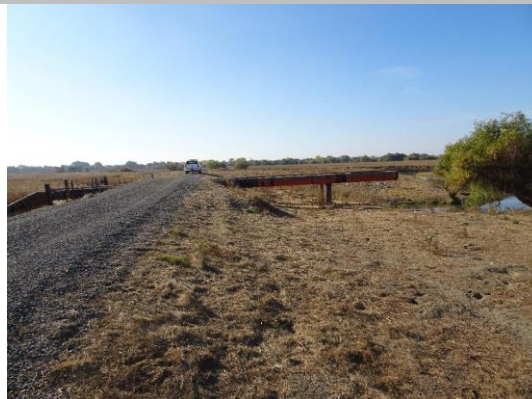
Photo 3 of 3 : UCIP\_FA\_2021\_64875\_90881.jpg

WS view: overview of WS slope

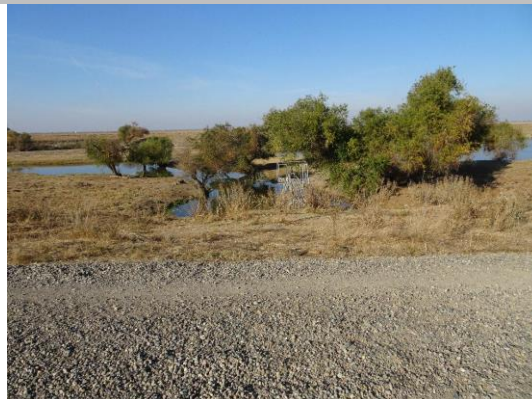
Photo 2 of 3 : UCIP\_FA\_2021\_64818\_90886.jpg

DS\_ID:19595  
 FS\_ID:64818  
 EP\_NO: 5983  
 Repair Type: Non-Urgent  
 EVAL Issue: Unauthorized Encroachment, installed decades prior  
 Crossing Status: Found  
 UCIP Comments: 11/16/2020 Record remains Non-Urgent. No permit was found authorizing this encroachment. CVFPB will need to review crossing to determine owner. DWR DMP internal inspection is pending and scheduled for 2021. (B. Singh - GEI, O. Magana - DWR UCIP)  
 FIELD\_STRUCT\_DESC: 60-inch corrugated metal gravity drainage pipe through the levee, 21 feet below the crown. Concrete U-shaped headwall and splash apron on the landside (LS) end. 7-foot by 8-foot by 20.5-foot concrete drainage structure around the LS end of the pipe. Flap gate over pipe opening inside drainage structure. Pump on discharge structure on the LS slope. Steel discharge pipe through the upstream wall of the structure. (Construction of a drainage pump discharge structure at the LS toe and appurtenances on preexisting drainage pipe authorized under Permit No. 5983, 1968 - Turner Island Water District). [Additional Reference(s): DWR Levee Log, 2002 (HLM 19.33), listed as a 60-inch corrugated metal pipe (CMP). USACE San Joaquin O&M Manual, Unit 601 Part 1 (SJR601.1), 1967, Revised 25 May 2011, (HLM 19.34), listed as a 60-inch CMP].

WS view: overview of WS

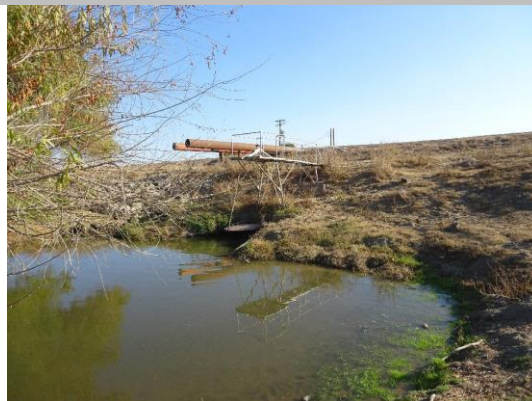
Photo 3 of 3 : UCIP\_FA\_2021\_64818\_90887.jpg

WS view: view of outlet on WS toe with gate open

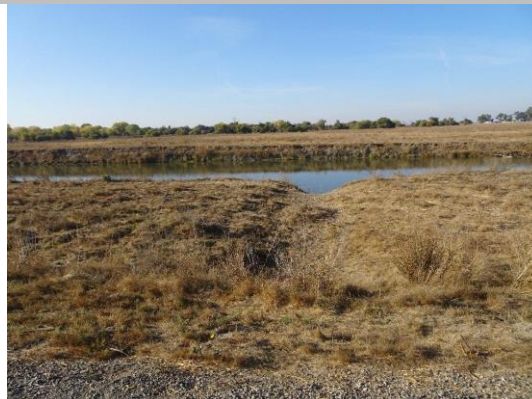
Photo 1 of 3 : UCIP\_FA\_2021\_64819\_90890.jpg

DS\_ID:19596  
FS\_ID:64819  
EP\_NO: N/A  
Repair Type: Non-Urgent  
EVAL Issue: Unauthorized Encroachment, installed decades prior  
Crossing Status: Found  
UCIP Comments: 11/16/2020 Record remains Non-Urgent. No permit was found authorizing this encroachment. CVFPB will need to review crossing to determine owner. DWR DMP has not found internal issues, LOF between 1 and 2. Recommend inspection in 5 years. (B. Singh - GEI, O. Magana - DWR UCIP)04/25/2014 Dense vegetation limits the inspector's visibility to identify signs of pipe failure (leaks) along the waterward slope. Recommend removing vegetation along pipe alignment to conduct proper inspection of structure. Dense vegetation blocks both waterward and landward headwalls. Sediment buildup in pipe visible from landward side. (O. Magana - DWR UCIP)  
FIELD\_STRUCT\_DESC: 24-inch corrugated metal gravity drainage pipe through the levee, 8 feet below the crown. Flap gate on the waterside (WS) end. Brass cap No. 40 bench mark (BM) on the headwall on the landside (LS). [Additional Reference(s): DWR Levee Log, 2002 (HLM 19.54), listed as a 24-inch corrugated metal pipe (CMP). USACE San Joaquin O&M Manual, Unit 601 Part 1 (SJR601.1), 1967, Revised 25 May 2011, (HLM 19.54), listed as a 24-inch CMP].

WS view: overview of WS

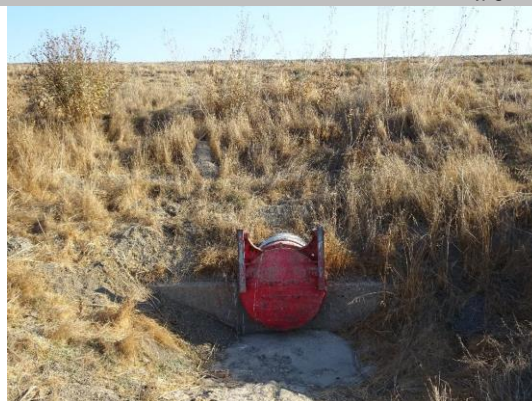
Photo 2 of 3 : UCIP\_FA\_2021\_64819\_90889.jpg

WS view: concrete headwall, flap gate, and WS slope visible on WS.

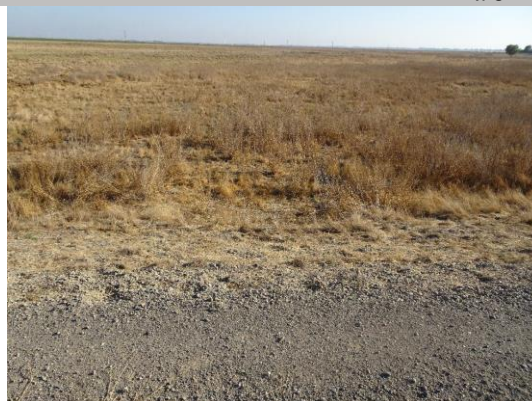
Photo 3 of 3 : UCIP\_FA\_2021\_64819\_90891.jpg

LS view: overview of LS

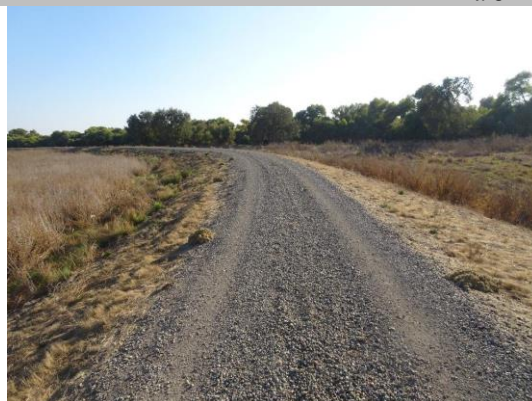
Photo 1 of 3 : UCIP\_FA\_2021\_64876\_90896.jpg

DS\_ID:19597  
 FS\_ID:64876  
 EP\_NO: N/A  
 Repair Type: Non-Urgent  
 EVAL Issue: Unauthorized Encroachment, installed decades prior  
 Crossing Status: Indicator Found  
 UCIP Comments: 11/16/2020 Record remains Non-Urgent. No permit was found authorizing this encroachment. CVFPB will need to review crossing to determine owner. DWR DMP internal inspection is pending and scheduled for 2021. (B. Singh - GEI, O. Magana - DWR UCIP)04/25/2014 No photos available for crossing--crossing missed. Recommend taking photos to confirm status of crossing. (O. Magana - DWR UCIP)  
 FIELD\_STRUCT\_DESC: 24-inch corrugated metal gravity drainage pipe through the levee, 8 feet below the crown. Flap gate on the waterside (WS) end. Brass cap No. 40 bench mark (BM) on the headwall on the landside (LS). [Additional Reference(s): DWR Levee Log, 2002 (HLM 19.82), listed as a 24-inch corrugated metal pipe (CMP). USACE San Joaquin O&M Manual, Unit 601 Part 1 (SJR601.1), 1967, Revised 25 May 2011, (HLM 19.81), listed as a 24-inch CMP].

Overview of levee crown looking u/s

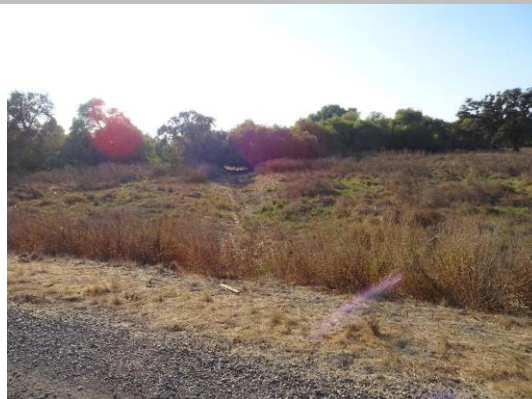
Photo 2 of 3 : UCIP\_FA\_2021\_64876\_90897.jpg

WS view: view of WS

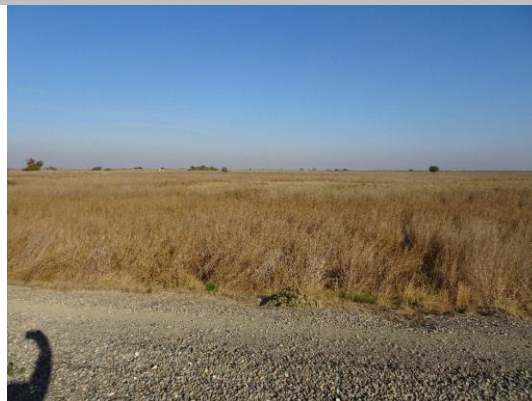
Photo 3 of 3 : UCIP\_FA\_2021\_64876\_90898.jpg

LS view: view of LS

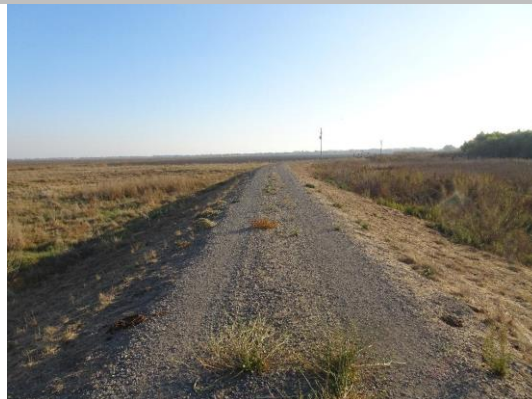
Photo 1 of 3 : UCIP\_FA\_2021\_64821\_90903.jpg

Comment Code					
Inspector Comment					
DS_ID:19598 FS_ID:64821 EP_NO: N/A Repair Type: Non-Urgent EVAL Issue: Limited Inspection/No UCIP Evaluation Crossing Status: Found UCIP Comments: 11/16/2020 Record remains Non-Urgent. Limited access due to steep slopes. No permit was found authorizing this encroachment. CVFPB will need to review crossing to determine owner. DWR DMP internal inspection is pending and scheduled for 2021. (B. Singh - GEI, O. Magana - DWR UCIP)04/25/2014 Recommend removing vegetation and sediment buildup from both waterward and landward concrete headwalls. (O. Magana - DWR UCIP) FIELD_STRUCT_DESC: 24-inch corrugated metal gravity drainage pipe through the levee, 8.5 feet below the crown. Flap gate on the waterside (WS) end. Brass cap No. 40 bench mark (BM) on the headwall on the landside (LS). [Additional Reference(s): DWR Levee Log, 2002 (HLM 20.19), listed as a 24-inch corrugated metal pipe (CMP). USACE San Joaquin O&M Manual, Unit 601 Part 1 (SJR601.1), 1967, Revised 25 May 2011, (HLM 20.18), listed as a 24-inch CMP]. FS Date: 11/16/2020

Overview of levee crown looking upstream

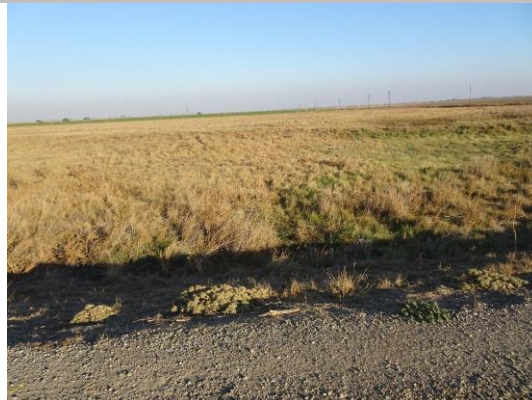
Photo 2 of 3 : UCIP\_FA\_2021\_64821\_93061.jpg

LS view: overview of LS.

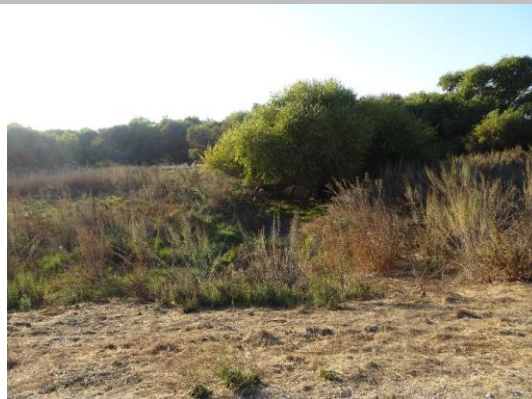
Photo 3 of 3 : UCIP\_FA\_2021\_64821\_93060.jpg

WS view: overview of WS.

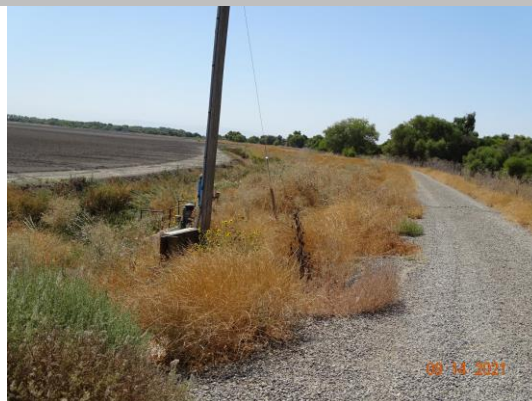
Photo 1 of 1 : FA\_2021\_NA0010\_118\_137\_20210927\_00297.jpg

LM Start	20.25	Rating **	U	Issue No.	137
LM End	22.08	Issue Type +	Ma	Location *	LS
Category	Earthen Levee			GPS Latitude/Longitude	
				Start	End
Item	Vegetation			37.193697 °	37.171726 °
				-120.760132 °	-120.754611 °
DWR ID	DWR_NA0010_01_f _ 2021_137				
Comment Code					
V1 : Control annual grass and weeds on the levee slopes and easements.					
Inspector Comment

View of vegetation on the landside slope. (Fall 2021)

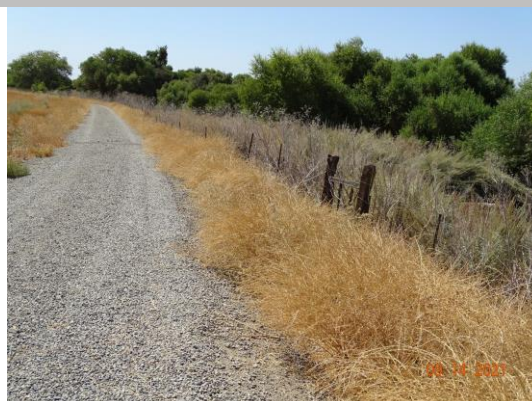
Photo 1 of 1 : FA\_2021\_NA0010\_118\_135\_20210927\_00298.jpg

LM Start	20.25	Rating **	U	Issue No.	135
LM End	22.08	Issue Type +	Ma	Location *	WS
Category	Earthen Levee			GPS Latitude/Longitude	
				Start	End
Item	Vegetation			37.193692 °	37.171716 °
				-120.760132 °	-120.754609 °
DWR ID	DWR_NA0010_01_f_2021_135				
Comment Code					
V1 : Control annual grass and weeds on the levee slopes and easements.					
Inspector Comment

View of the waterside slope looking upstream. (Fall 2021)

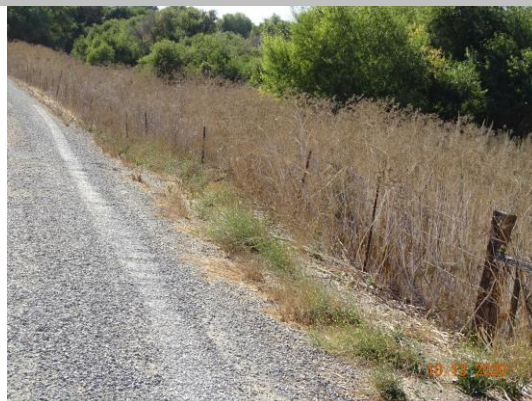
Photo 1 of 1 : FA\_2021\_NA0010\_118\_106\_20210830\_00010.jpg

LM Start	20.25	Rating **	M	Issue No.	106
LM End	22.51	Issue Type +	En	Location *	WS
Category	Earthen Levee			GPS Latitude/Longitude	
				Start	End
Item	Encroachments			37.193663 °	37.166957 °
				-120.760148 °	-120.750080 °
DWR ID	DWR_NA0010_01_f_2020_106				
Comment Code					
FE : Fence					
Inspector Comment

Barbed wire fence along the waterside slope. (Fall 2020)

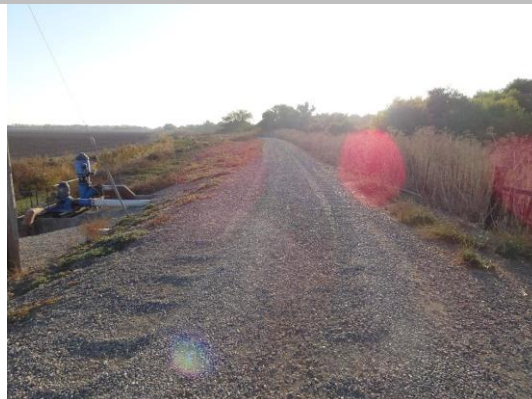
Photo 1 of 3 : UCIP\_FA\_2021\_64877\_91024.jpg

LM Start	20.26	Rating **	M	Issue No.	1266	
LM End	20.26	Issue Type +	En	Location *		
Category	Supplemental			GPS Latitude/Longitude		
				Start		End
Item	DWR UCIP Field Study			37.193618 °	37.193618 °	
				-120.760284 °	-120.760284 °	
DWR ID	19726					
Comment Code						
Inspector Comment						
DS_ID:19726 FS_ID:64877 EP_NO: N/A Repair Type: Non-Urgent EVAL Issue: Pipe Not Found Crossing Status: Not Found UCIP Comments: 11/16/2020 Record remains Non-Urgent. PVC pipe not found. No permit was found authorizing this encroachment. CVFPB will need to review crossing to determine owner. (B. Singh - GEI, O. Magana - DWR UCIP) FIELD_STRUCT_DESC: Polyvinyl chloride (PVC) gravity drainage pipe of an unknown size appears to go through the levee, at an unknown depth. Standpipe on the landside (LS). Provide a field description of this crossing. FS Date: 11/16/2020

Overview of levee looking u/s

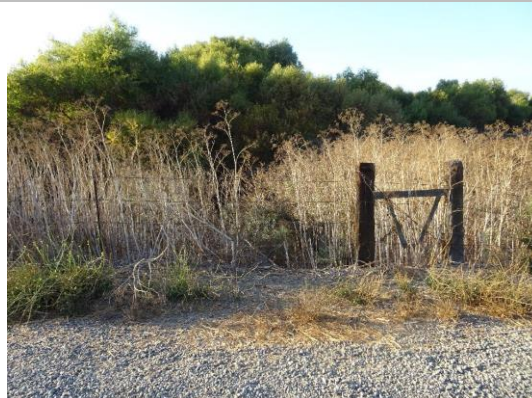
Photo 2 of 3 : UCIP\_FA\_2021\_64877\_91025.jpg

WS view: overview of WS

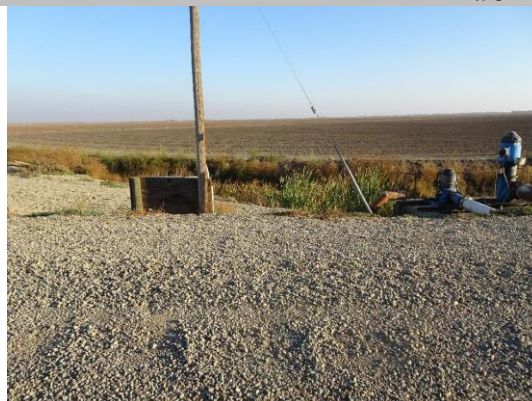
Photo 3 of 3 : UCIP\_FA\_2021\_64877\_91026.jpg

LS view: overview of LS

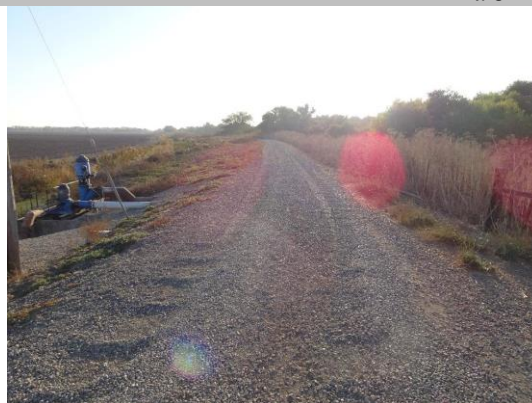
Photo 1 of 3 : UCIP\_FA\_2021\_64878\_91023.jpg

DS\_ID:19599  
 FS\_ID:64878  
 EP\_NO: N/A  
 Repair Type: Non-Urgent  
 EVAL Issue: Unauthorized Encroachment  
 Crossing Status: Found  
 UCIP Comments: 11/16/2020 Record remains Non-Urgent. Fence on the WS inhibited proper inspection. No permit was found authorizing this encroachment. CVFPB will need to review crossing to determine owner. (B. Singh - GEI, O. Magana - DWR UCIP)7/19/2016 same as previous inspection. crossing was downgraded from Urgent to Non-Urgent due to metal rod not interfering with flap gate. (O. Magana - DWR UCIP)4/25/2014 Unauthorized crossing through pipe. Line was pushed through existing crossing. Need to contact owner. Also sediment buildup in pipe visible from landward side--recommend clearing. (O. Magana - DWR UCIP)  
 FIELD\_STRUCT\_DESC: 24-inch corrugated metal gravity drainage pipe through the levee, 5 feet below the crown. Flap gate on the waterside (WS) end. No permit for this crossing. [Additional Reference(s): DWR Levee Log, 2002 (HLM 20.27), listed as a 24-inch corrugated metal pipe (CMP)].

Overview of levee crown

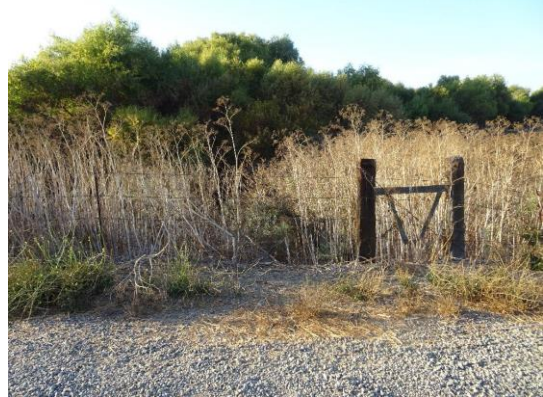
Photo 2 of 3 : UCIP\_FA\_2021\_64878\_91019.jpg

View waterward. Fence and dense vegetation inhibited proper inspection

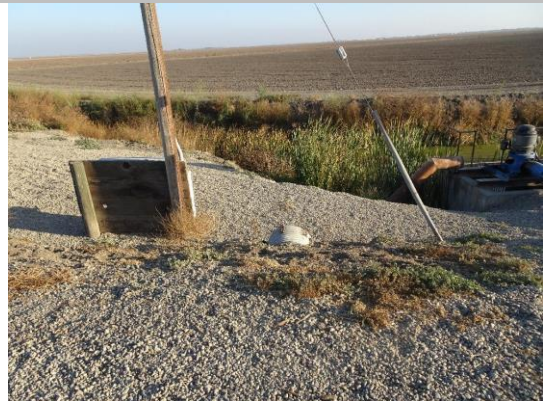
Photo 3 of 3 : UCIP\_FA\_2021\_64878\_91020.jpg

View landward

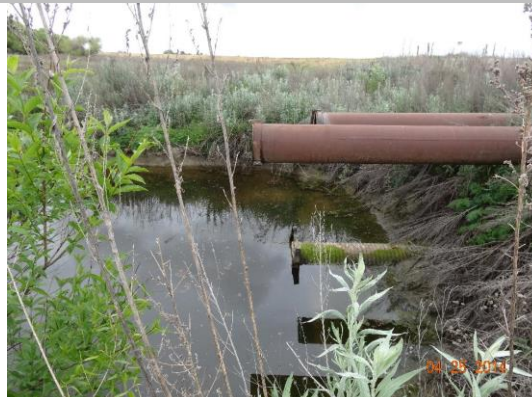
Photo 2 of 3 : UCIP\_FA\_2021\_64831\_66309.jpg

DS\_ID:19600  
FS\_ID:64831  
EP\_NO: N/A  
Repair Type: Non-Urgent  
EVAL Issue: Limited Inspection/No UCIP Evaluation  
Crossing Status: Found  
UCIP Comments: 11/16/2020 Record remains Non-Urgent. Dense vegetation and fence on the WS prevented proper inspection of pipe. No permit has been found authorizing this pipe. CVFPB will need to review crossing to determine owner. (O. Magana - DWR UCIP)04/25/2014 Crossing partially submersed--no signs of failure of pipe present along pipe alignment. Recommend contacting owner to determine status of crossing and condition. (O. Magana - DWR UCIP)  
FIELD\_STRUCT\_DESC: 36-inch corrugated metal gravity drainage pipe through the levee, 10.5 feet below the crown. Flap gate on the waterside (WS) end. Brass cap No. 40 bench mark (BM) on the headwall on the landside (LS). [Additional Reference(s): DWR Levee Log, 2002 (HLM 20.28), listed as a 36-inch corrugated metal pipe (CMP). USACE San Joaquin O&M Manual, Unit 601 Part 1 (SJR601.1), 1967, Revised 25 May 2011, (HLM 20.27), listed as a 36-inch CMP].

Multiple crossings visible on waterward side--36 inch CMP is submersed in water.

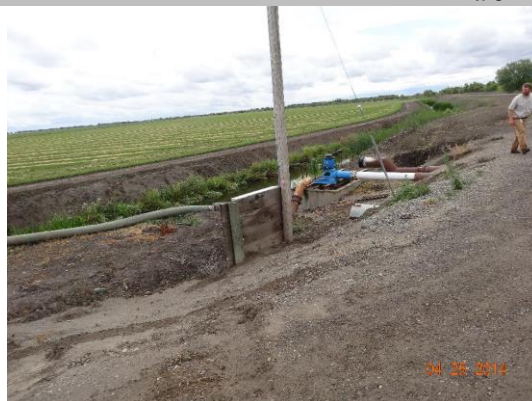
Photo 3 of 3 : UCIP\_FA\_2021\_64831\_66307.jpg

View of landward side.

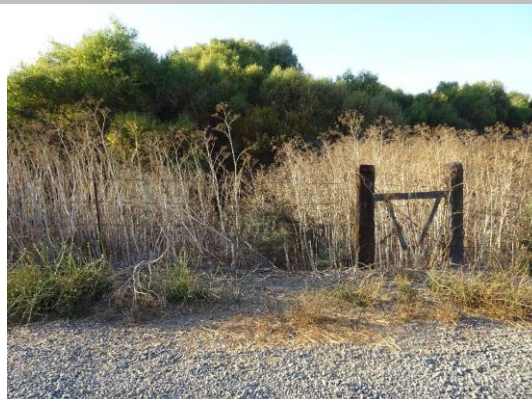
Photo 2 of 3 : UCIP\_FA\_2021\_64879\_91015.jpg

DS\_ID:24873  
 FS\_ID:64879  
 EP\_NO: N/A  
 Repair Type: Non-Urgent  
 EVAL Issue: Unauthorized Encroachment  
 Crossing Status: Found  
 UCIP Comments: 11/16/2020 Record remains Non-Urgent. Dense vegetation and fence on the WS inhibited proper inspection. No permit was found authorizing this encroachment. CVFPB will need to review crossing to determine owner. System description was updated based on measured diameters for the outer pipe and sleeved pipe. (B. Singh - GEI, O. Magana - DWR UCIP)04/25/2014 Dense vegetation limits the inspector's visibility to identify signs of pipe failure (leaks) along the waterward slope. Recommend removing vegetation along pipe alignment to conduct proper inspection of structure. (DWR UCIP - O. Magana)  
 FIELD\_STRUCT\_DESC: 9-inch steel drainage discharge pipe sleeved through a 14-inch steel pipe through levee, at an unknown depth.  
 FS Date: 11/16/2020

View waterward. Dense vegetation and fencing

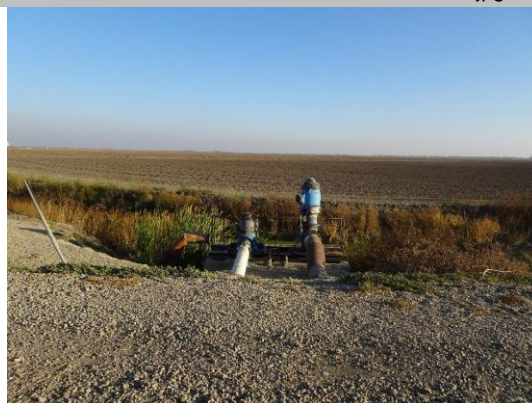
Photo 3 of 3 : UCIP\_FA\_2021\_64879\_91017.jpg

View landward and pipes

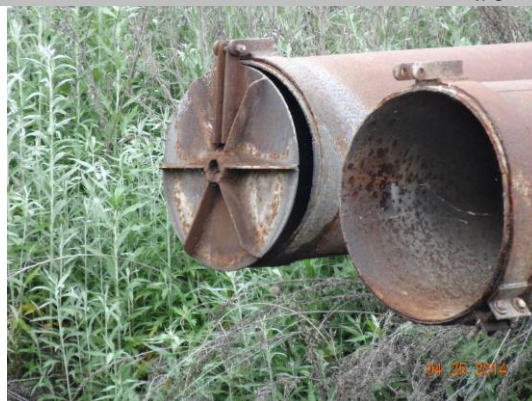
Photo 1 of 3 : UCIP\_FA\_2021\_64833\_71442.jpg

DS\_ID:24874  
FS\_ID:64833  
EP\_NO: N/A  
Repair Type: Non-Urgent  
EVAL Issue: Unauthorized Encroachment  
Crossing Status: Found  
UCIP Comments: 11/16/2020 Record remains Non-Urgent. Dense vegetation and fence on the WS prevented proper inspection of pipe. No permit has been found authorizing this pipe. CVFPB will need to review crossing to determine owner. (O. Magana - DWR UCIP)04/25/2014 Dense vegetation limits the inspector's visibility to identify signs of pipe failure (leaks) along the waterward slope. Recommend removing vegetation along pipe alignment to conduct proper inspection of structure. (O. Magana - DWR UCIP)  
FIELD\_STRUCT\_DESC: 16-inch steel drainage discharge pipe sleeved through a 18-inch steel pipe through levee, at an unknown depth. Concrete intake structure located on the LS toe.  
FS Date: 11/6/2020

Outlets visible on waterward side.

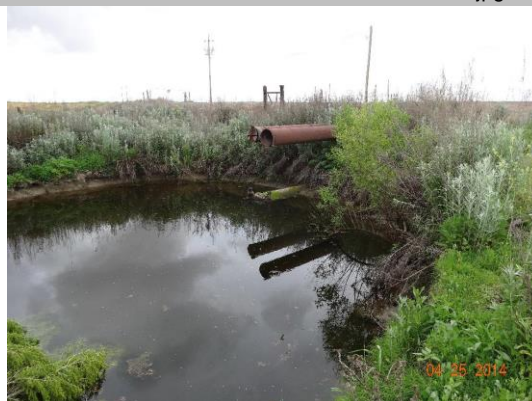
Photo 2 of 3 : UCIP\_FA\_2021\_64833\_71441.jpg

View of waterward side.

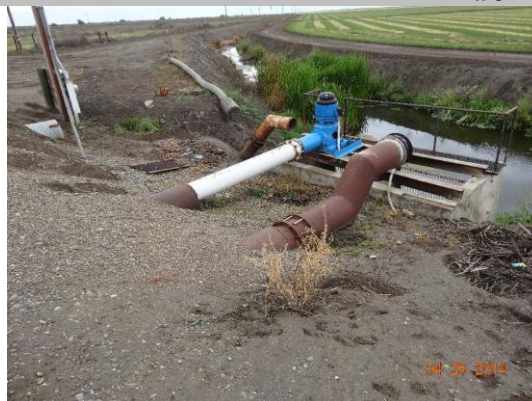
Photo 3 of 3 : UCIP\_FA\_2021\_64833\_71440.jpg

View of landward side.

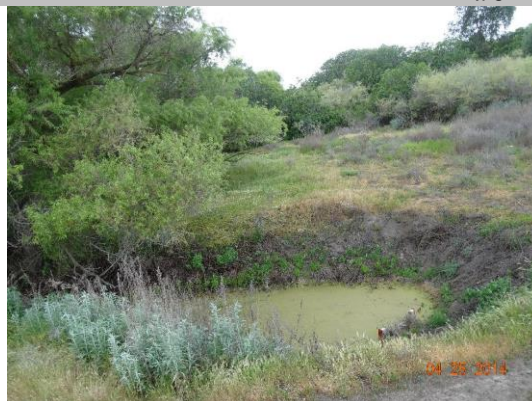
Photo 1 of 3 : UCIP\_FA\_2021\_64822\_66312.jpg

DS\_ID:19603  
FS\_ID:64822  
EP\_NO: N/A  
Repair Type: Non-Urgent  
EVAL Issue: Unauthorized Encroachment, installed decades prior  
Crossing Status: Found  
UCIP Comments: 05/06/2021 Record remains Non-Urgent. This crossing appears to be non-functional based on the 2014 UCIP inspection. No field inspection has been completed by UCIP. DWR DMP internal inspection is pending and scheduled for 2021. Recommend having UCIP inspector or Levee inspector take current photos of the site. (O. Magana - DWR UCIP)04/25/2014 Crossing is non-functional--crossing buried on landward side. Need to contact owner to determine status of crossing. If crossing is no longer used need to coordinate with CVFPB for proper abandonment. (O. Magana - DWR UCIP)  
FIELD\_STRUCT\_DESC: 36-inch corrugated metal gravity drainage pipe through the levee, 11.5 feet below the crown. Flap gate on the waterside (WS) end. Brass cap No. 40 bench mark (BM) on the headwall on the landside (LS). [Additional Reference(s): DWR Levee Log, 2002 (HLM 21.41), listed as a 36-inch corrugated metal pipe (CMP). USACE San Joaquin O&M Manual, Unit 601 Part 1 (SJR601.1), 1967, Revised 25 May 2011, (HLM 21.40), listed as a 36-inch CMP].

View of waterward side.

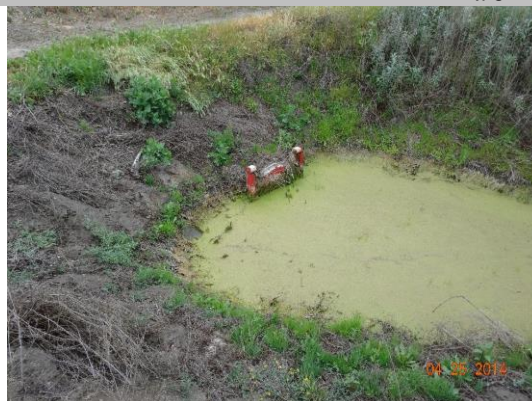
Photo 2 of 3 : UCIP\_FA\_2021\_64822\_66313.jpg

Flap gate half way submersed located on waterward side.

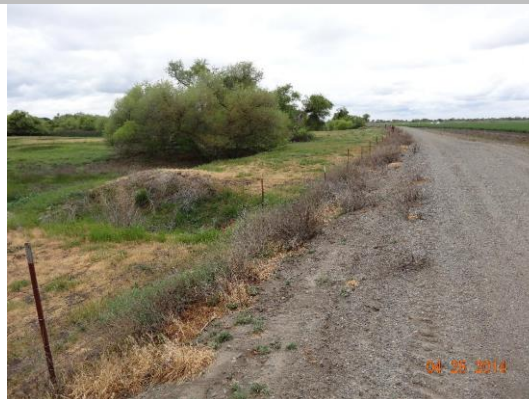
Photo 1 of 3 : UCIP\_FA\_2021\_64823\_65697.jpg

DS\_ID:19604  
 FS\_ID:64823  
 EP\_NO: N/A  
 Repair Type: Non-Urgent  
 EVAL Issue: Unauthorized Encroachment, installed decades prior  
 Crossing Status: Found  
 UCIP Comments: 05/06/2021 Record remains Non-Urgent. This crossing appears to be non-functional based on the 2014 UCIP inspection. No field inspection has been completed by UCIP. DWR DMP internal inspection is pending and scheduled for 2021. Recommend having UCIP inspector or Levee inspector take current photos of the site. (O. Magana - DWR UCIP)04/25/2014 Non-functional crossing-landward side is buried. Need to contact owner to determine status of crossing. If crossing is no longer used need to coordinate with CVFPB for proper abandonment. (O. Magana - DWR UCIP)  
 FIELD\_STRUCT\_DESC: 24-inch corrugated metal gravity drainage pipe through the levee, 9 feet below the crown. Flap gate on the waterside (WS) end. Brass cap No. 40 bench mark (BM) on the headwall on the landside (LS). [Additional Reference(s): DWR Levee Log, 2002 (HLM 21.78), listed as a 24-inch corrugated metal pipe (CMP). USACE San Joaquin O&M Manual, Unit 601 Part 1 (SJR601.1), 1967, Revised 25 May 2011, (HLM 21.76), listed as a 24-inch CMP].

View of waterward side.

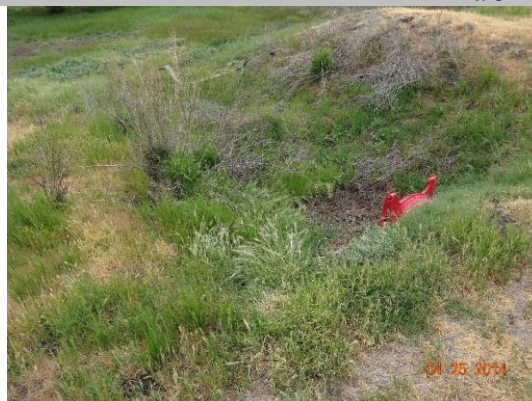
Photo 2 of 3 : UCIP\_FA\_2021\_64823\_65695.jpg

Flap gate visible on waterward side.

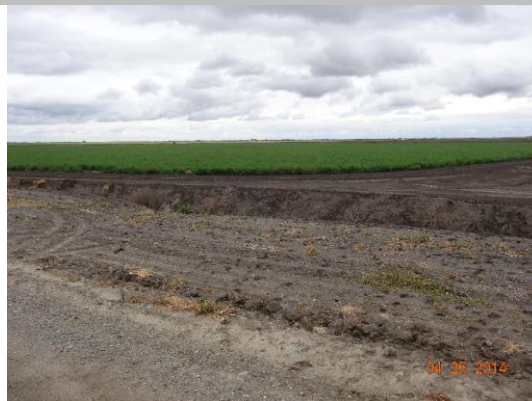
Photo 3 of 3 : UCIP\_FA\_2021\_64823\_65696.jpg

View of landward side.

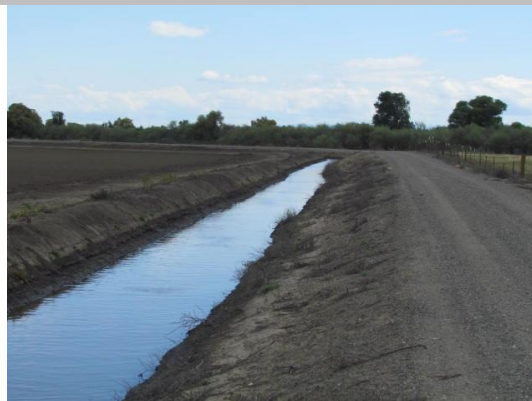
Photo 1 of 1 : FA\_2021\_NA0010\_118\_22\_20210830\_00005.jpg

LM Start	22.06	Rating **	U	Issue No.	22
LM End	22.52	Issue Type +	En	Location *	LS
Category	Earthen Levee			GPS Latitude/Longitude	
				Start	End
Item	Encroachments			37.172074 °	37.166906 °
				-120.754628 °	-120.749962 °
DWR ID	DWR_NA0010_01_s_2020_22				
Comment Code					
DT : Ditch					
Inspector Comment					
Ditch has encroached into landside toe and slope.

Looking upstream at irrigation at landside toe.

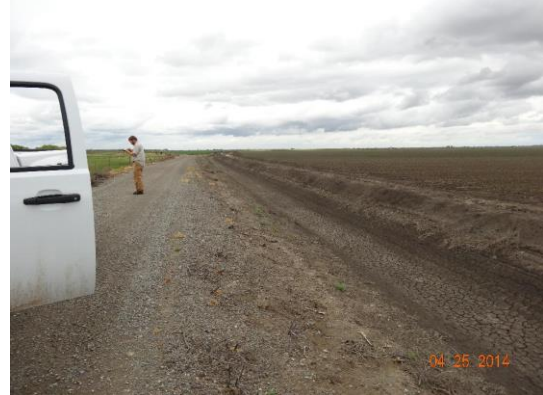
Photo 3 of 3 : UCIP\_FA\_2021\_64824\_65708.jpg

View of landward side.
