## Flood Control Project Maintenance Levee Inspections

### Fall 2021 Levee Maintenance Deficiency Summary Report

#### San Joaquin River Basin

NA0010 Lower San Joaquin Levee District	Overall LMA Rating	Total LMA Miles							
	U	191.27							
Rated Item	Maintenance Deficiency				Enforcement		Design & System Obsolescence		
	M Miles	U Miles	M + 4U Miles	Threshold %	M Miles	U Miles	M Miles	U Miles	
<i>Earthen Levee</i>									
Vegetation	47.00	9.57	85.28	44.59%					
Trim / Thin Trees	0.10		0.10	0.05%					
Encroachments	0.23	0.02	0.31	0.16%	9.29	0.59			
Animal Control	7.67	2.19	16.43	8.59%					
Slope Stability	0.05	0.01	0.09	0.05%					
Erosion / Bank Caving	0.13	0.81	3.37	1.76%					
Crown Surface / Depressions / Rutting	0.01		0.01	0.01%					
Repair Gates	0.02	0.02	0.10	0.05%					
<i>Rivers, Channels &amp; Designated Floodways</i>									
Encroachments					0.01	0.01			
<i>Supplemental</i>									
DWR Erosion Survey	0.12	0.17	0.80	0.42%					
DWR UCIP Field Study					1.29	0.05			
DWR UCIP LMA Responsibility									
<i>LMA Totals:</i>	55.33	12.79	106.49	55.67%	10.59	0.65	0.00	0.00

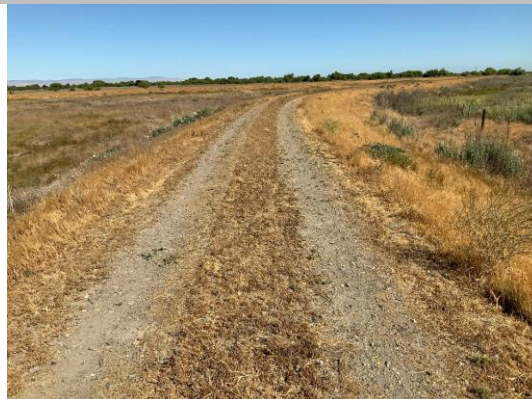
Photo 1 of 3 : UCIP\_FA\_2021\_67488\_100054.jpg

Comment Code						
Inspector Comment						
DS_ID:19652 FS_ID:67488 EP_NO: N/A Repair Type: Non-Urgent EVAL Issue: Limited Inspection/No UCIP Evaluation Crossing Status: Found UCIP Comments: 06/8/2021 Record remains Non-Urgent. There is dense vegetation around the LS pipe inlet, recommend removing to better inspect pipe. No permit was found authorizing this encroachment. CVFPB will need to review crossing to determine owner. The UCIP inspection was completed with GEI staff, P. Espinoza. (H. Dunn – GEI) 05/01/2014 Dense vegetation limits the inspector's visibility to identify signs of pipe failure (leaks) along the slope. Recommend removing vegetation along pipe alignment to conduct proper inspection of structure. (O. Magana - DWR UCIP) FIELD_STRUCT_DESC: 24-inch corrugated metal gravity drainage pipe through the levee, 11 feet below the crown. Flap gate on the waterside (WS) end. Brass cap No. 139 bench mark (BM) on the headwall on the landside (LS). [Additional Reference(s): DWR Levee Log, 2002 (HLM 0.24), listed as a 24-inch corrugated metal pipe (CMP). USACE San Joaquin O&M Manual, Unit 601 Part 1 (SJR 601.1), 1967, Revised 25 May 2011, (HLM 0.24), listed as a 24-inch CMP]. FS Date: 6/8/2021

Levee crown looking downstream.

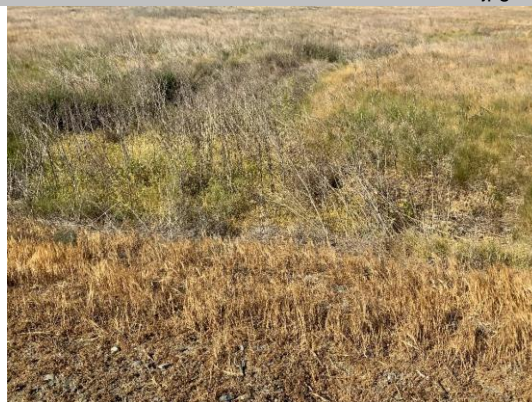
Photo 2 of 3 : UCIP\_FA\_2021\_67488\_100058.jpg

LS view: Toe from crown.

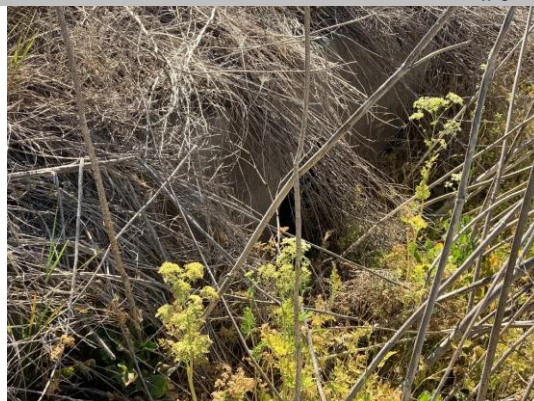
Photo 3 of 3 : UCIP\_FA\_2021\_67488\_100059.jpg

LS view: Close up of pipe inlet at toe, vegetation covering opening.

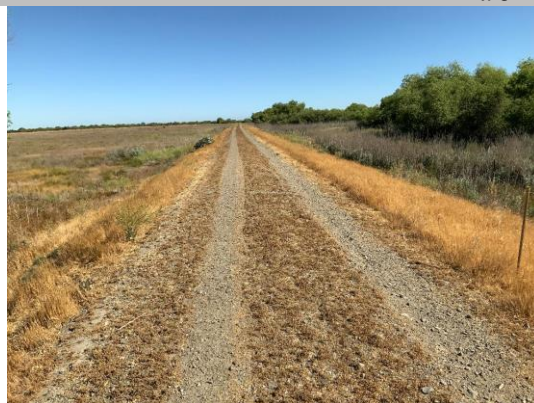
Photo 1 of 3 : UCIP\_FA\_2021\_67491\_100062.jpg

DS\_ID:19653  
 FS\_ID:67491  
 EP\_NO: N/A  
 Repair Type: Non-Urgent  
 EVAL Issue: Maintenance Compliance Issue  
 Crossing Status: Found  
 UCIP Comments: 06/8/2021 The record remains Non-Urgent. Some vegetation debris inside LS pipe inlet, recommend removal. No permit was found authorizing this encroachment. CVFPB will need to review crossing to determine owner. The UCIP inspection was completed with GEI staff, P. Espinoza. (H. Dunn – GEI) 05/01/2014 Dense vegetation limits the inspector's visibility to identify signs of pipe failure (leaks) along the slope. Recommend removing vegetation along pipe alignment to conduct proper inspection of structure. (O. Magana - DWR UCIP)  
 FIELD\_STRUCT\_DESC: 24-inch corrugated metal gravity drainage pipe through the levee, 14.8 feet below the crown. Flap gate on the waterside (WS) end. Brass cap No. 138 bench mark (BM) on the headwall on the landside (LS). [Additional Reference(s): DWR Levee Log, 2002 (HLM 0.69), listed as a 24-inch corrugated metal pipe (CMP). USACE San Joaquin O&M Manual, Unit 601 Part 1 (SJR 601.1), 1967, Revised 25 May 2011, (HLM 0.67), listed as a 24-inch CMP].

Levee crown looking downstream.

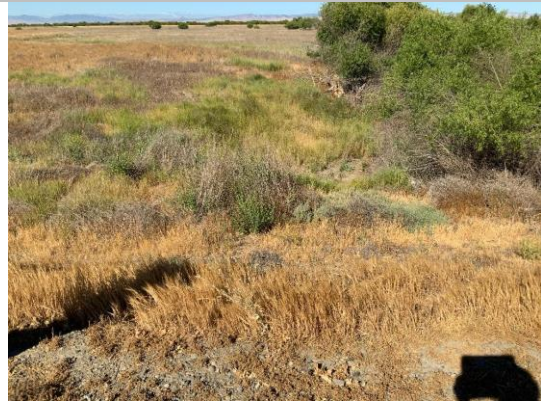
Photo 2 of 3 : UCIP\_FA\_2021\_67491\_100063.jpg

LS view: Toe from crown.

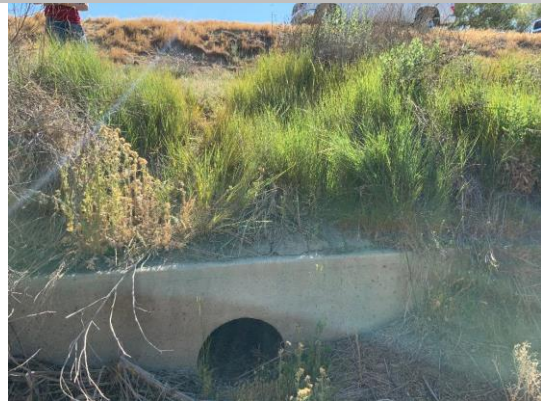
Photo 3 of 3 : UCIP\_FA\_2021\_67491\_100064.jpg

LS view: Slope, headwall, and inlet at toe.

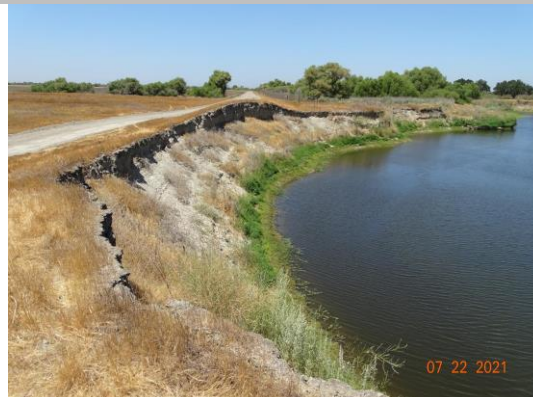
Photo 1 of 3 : SJR2021\_NA0010U02ARM129.22\_1.JPG

Site ID: NA0010U02ARM129.22  
 07/22/2021: No significant changes were observed since the previous inspection.  
 08/20/2020: This site was discovered during the DWR Spring 2012 Levee Inspections. A 250-ft long levee section has completely eroded away and no longer provides adequate flood protection. Note: Unit 2A is in the process of being turned over to State Parks.

7/22/2021: View of the erosion and missing levee segment looking downstream.

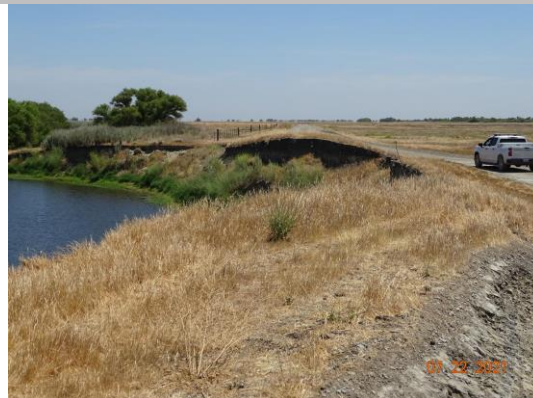
Photo 2 of 3 : SJR2021\_NA0010U02ARM129.22\_4.JPG

7/22/2021: View of the eroded levee looking upstream.

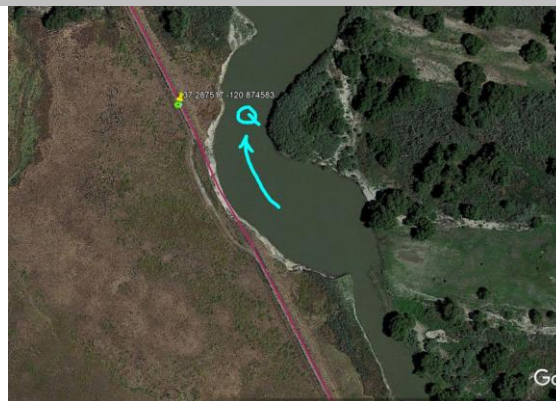
Photo 3 of 3 : SJR2021\_DWR\_NA0010\_02A\_s\_2012\_5\_GE.JPG

8/20/2020: Aerial view of the erosion site (Google Earth Imagery from 7/18/2019).

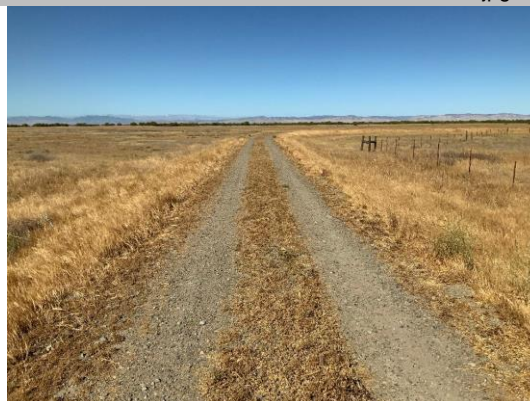
Photo 1 of 3 : UCIP\_FA\_2021\_67490\_100074.jpg

DS\_ID:19654  
FS\_ID:67490  
EP\_NO: N/A  
Repair Type: Non-Urgent  
EVAL Issue: Limited Inspection/No UCIP Evaluation  
Crossing Status: Found  
UCIP Comments: 06/8/2021 The record remains Non-Urgent. Dense vegetation on LS slope, could not inspect pipe inlet, recommend clearing. No permit was found authorizing this encroachment. CVFPB will need to review crossing to determine owner. The UCIP inspection was completed with GEI staff, P. Espinoza. (H. Dunn – GEI)

Levee crown looking downstream.

05/01/2014 Dense vegetation limits the inspector's visibility to identify signs of pipe failure (leaks) along the slope. Recommend removing vegetation along pipe alignment to conduct proper inspection of structure. Sediment buildup in pipe recommend clearing. (O. Magana - DWR UCIP)  
FIELD\_STRUCT\_DESC: 24-inch corrugated metal gravity drainage pipe through the levee, 8.6 feet below the crown. Flap gate on the waterside (WS) end. Brass cap No. 137 bench mark (BM) on the headwall on the landside (LS). [Additional Reference(s): DWR Levee Log, 2002 (HLM 1.03), listed as a 24-inch corrugated metal pipe (CMP). USACE San Joaquin O&M Manual, Unit 601 Part 1 (SJR 601.1), 1967, Revised 25 May 2011, (HLM 1.02), listed as a 24-inch CMP].  
FS Date: 6/8/2021

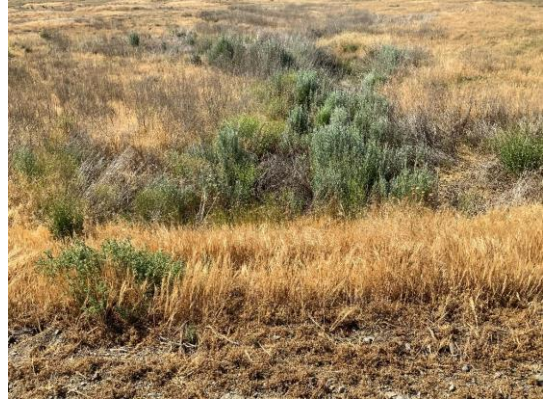
Photo 2 of 3 : UCIP\_FA\_2021\_67490\_100075.jpg

LS view: Toe from crown.

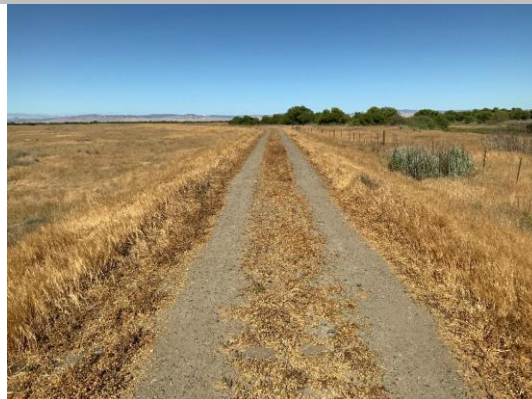
Photo 1 of 3 : UCIP\_FA\_2021\_67492\_100079.jpg

DS\_ID:19655  
FS\_ID:67492  
EP\_NO: N/A  
Repair Type: Non-Urgent  
EVAL Issue: Limited Inspection/No UCIP Evaluation  
Crossing Status: Found  
UCIP Comments: 06/8/2021 The record remains Non-Urgent. Dense vegetation over LS pipe inlet, recommend clearing out for easier pipe inspection. No permit was found authorizing this encroachment. CVFPB will need to review crossing to determine owner. The UCIP inspection was completed with GEI staff, P. Espinoza. (H. Dunn – GEI)

Levee crown looking downstream.

05/01/2014 Dense vegetation limits the inspector's visibility to identify signs of pipe failure (leaks) along the slope. Recommend removing vegetation along pipe alignment to conduct proper inspection of structure. (O. Magana - DWR UCIP)

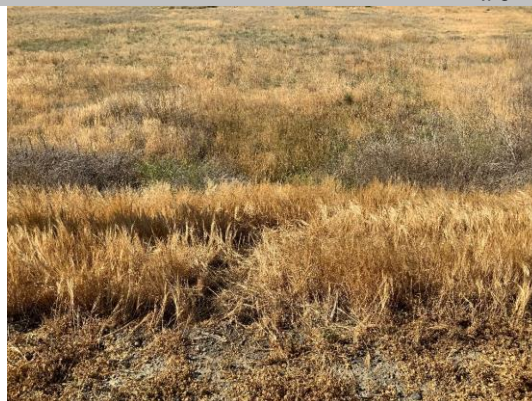
Photo 2 of 3 : UCIP\_FA\_2021\_67492\_100080.jpg

LS view: Toe from crown.

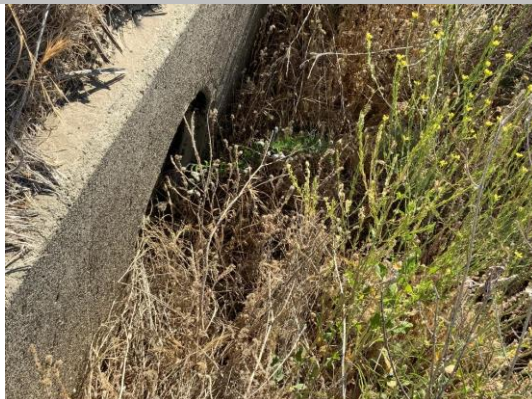
Photo 3 of 3 : UCIP\_FA\_2021\_67492\_100081.jpg

LS view: Headwall and inlet barely visible at toe due to vegetation.

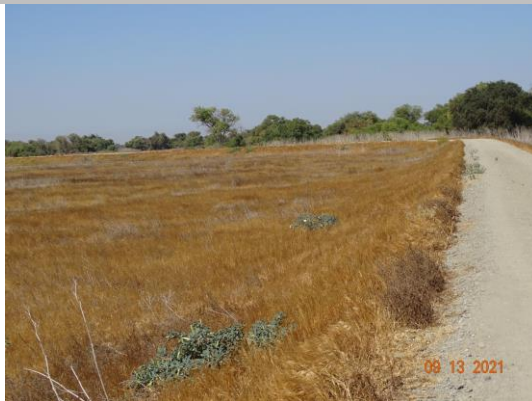
Photo 1 of 1 : FA\_2021\_NA0010\_119\_25\_20210927\_00069.jpg

LM Start	1.25	Rating **	M	Issue No.	25
LM End	2.53	Issue Type +	Ma	Location *	LS
Category	Earthen Levee			GPS Latitude/Longitude	
				Start	End
Item	Vegetation			37.286246 °	37.289799 °
				-120.867335 °	-120.847620 °
DWR ID	DWR_NA0010_02A_f_2021_25				
Comment Code					
V1 : Control annual grass and weeds on the levee slopes and easements.					
Inspector Comment					
maybe remove

Looking downstream along the landside slope. (Fall 2021)

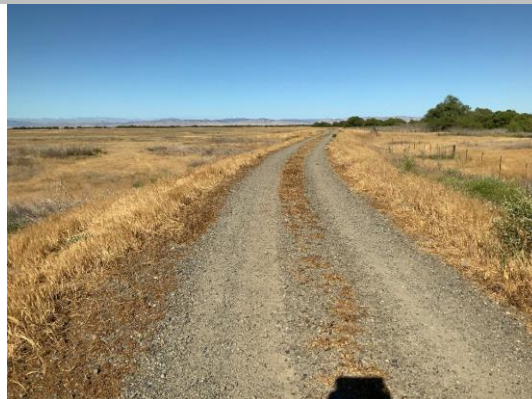
Photo 1 of 3 : UCIP\_FA\_2021\_67628\_100086.jpg

DS\_ID:19656  
FS\_ID:67628  
EP\_NO: N/A  
Repair Type: Non-Urgent  
EVAL Issue: Limited Inspection/No UCIP Evaluation  
Crossing Status: Found  
UCIP Comments: 06/8/2021 The record remains Non-Urgent. Dense LS vegetation limits inspection of pipe inlet, headwall and inlet not visible at all, recommend clearing. WS flapgate seen with vegetation sticking out of it, recommend removal. No permit was found authorizing this encroachment. CVFPB will need to review crossing to determine owner. The UCIP inspection was completed with GEI staff, P. Espinoza. (H. Dunn – GEI) 05/01/2014 Dense vegetation limits the inspector's visibility to identify signs of pipe failure (leaks) along the slope. Recommend removing vegetation along pipe alignment to conduct proper inspection of structure. (O. Magana - DWR UCIP)  
FIELD\_STRUCT\_DESC: 36-inch corrugated metal gravity drainage pipe through the levee, 14.6 feet below the crown. Flap gate on the waterside (WS) end. Brass cap No. 135 bench mark (BM) on the headwall on the landside (LS). [Additional Reference(s): DWR Levee Log, 2002 (HLM 1.36), listed as a 36-inch corrugated metal pipe (CMP). USACE San Joaquin O&M Manual, Unit 601 Part 1 (SJR 601.1), 1967, Revised 25 May 2011, (HLM 1.34), listed as a 36-inch CMP].

Levee crown looking downstream.

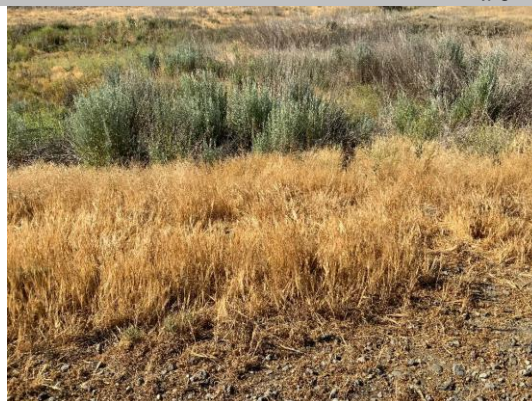
Photo 2 of 3 : UCIP\_FA\_2021\_67628\_100087.jpg

LS view: Toe from crown.

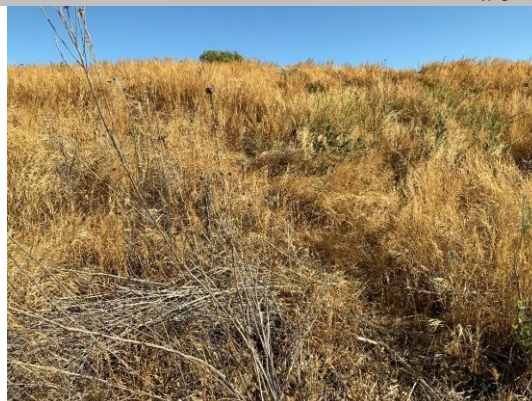
Photo 3 of 3 : UCIP\_FA\_2021\_67628\_100088.jpg

LS view: Slope from just above toe.

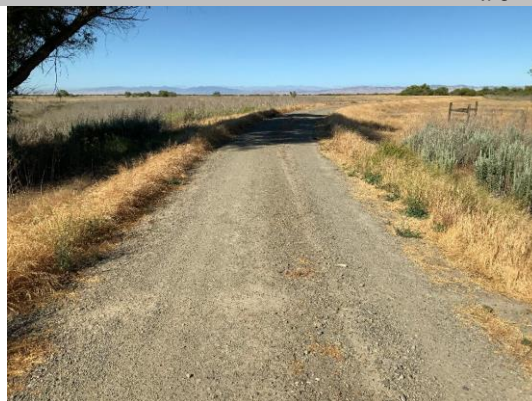
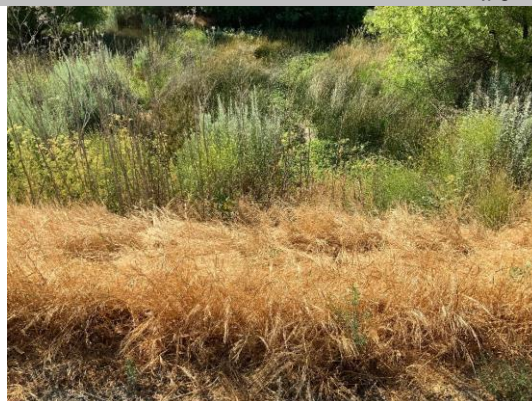
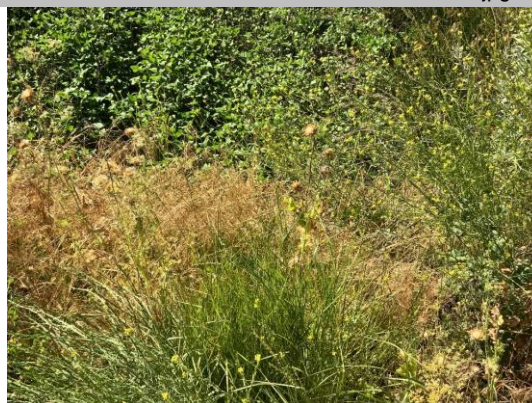
DS\_ID:19657  
 FS\_ID:67494  
 EP\_NO: N/A  
 Repair Type: Non-Urgent  
 EVAL Issue: Limited Inspection/No UCIP Evaluation  
 Crossing Status: Found  
 UCIP Comments: 06/8/2021 The record remains Non-Urgent. Both WS and LS pipe ends are heavily vegetated. Headwalls and flapgate were just barely visible, recommend removal of vegetation on both sides. No permit was found authorizing this encroachment. CVFPB will need to review crossing to determine owner. The UCIP inspection was completed with GEI staff, P. Espinoza. (H. Dunn – GEI) 05/01/2014  
 Dense vegetation limits the inspector's visibility to identify signs of pipe failure (leaks) along the slope. Recommend removing vegetation along pipe alignment to conduct proper inspection of structure. (O. Magana - DWR UCIP)  
 FIELD\_STRUCT\_DESC: 24-inch corrugated metal gravity drainage pipe through the levee, 10.2 feet below the crown. Flap gate on the waterside (WS) end. Brass cap No. 135 bench mark (BM) on the headwall on the landside (LS). [Additional Reference(s): DWR Levee Log, 2002 (HLM 1.63), listed as a 24-inch corrugated metal pipe (CMP). USACE San Joaquin O&M Manual, Unit 601 Part 1 (SJR 601.1), 1967, Revised 25 May 2011, (HLM 1.62), listed as a 24-inch CMP].

LS view: Headwall and inlet covered in vegetation at toe.

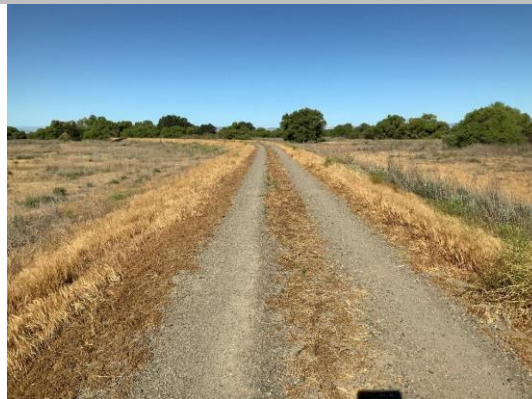
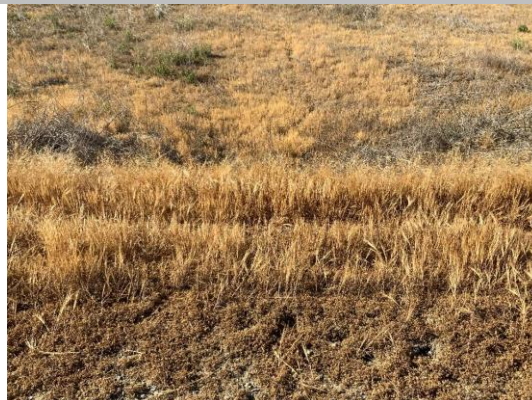
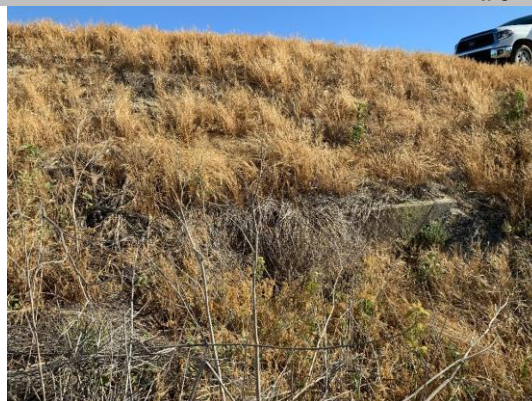
DS\_ID:19658  
FS\_ID:67495  
EP\_NO: N/A  
Repair Type: Non-Urgent  
EVAL Issue: Limited Inspection/No UCIP Evaluation  
Crossing Status: Found  
UCIP Comments: 06/8/2021 The record remains Non-Urgent. Dense vegetation covering LS pipe inlet, recommend removal. No permit was found authorizing this encroachment. CVFPB will need to review crossing to determine owner. The UCIP inspection was completed with GEI staff, P. Espinoza. (H. Dunn – GEI) 05/01/2014 Dense vegetation limits the inspector's visibility to identify signs of pipe failure (leaks) along the slope. Recommend removing vegetation along pipe alignment to conduct proper inspection of structure. (O. Magana - DWR UCIP)  
FIELD\_STRUCT\_DESC: 24-inch corrugated metal gravity drainage pipe through the levee, 10.7 feet below the crown. Flap gate on the waterside (WS) end. Brass cap No. 135 bench mark (BM) on the headwall on the landside (LS). [Additional Reference(s): DWR Levee Log, 2002 (HLM 1.88), listed as a 24-inch corrugated metal pipe (CMP). USACE San Joaquin O&M Manual, Unit 601 Part 1 (SJR 601.1), 1967, Revised 25 May 2011, (HLM 1.86), listed as a 24-inch CMP].

LS view: Slope and headwall from toe.

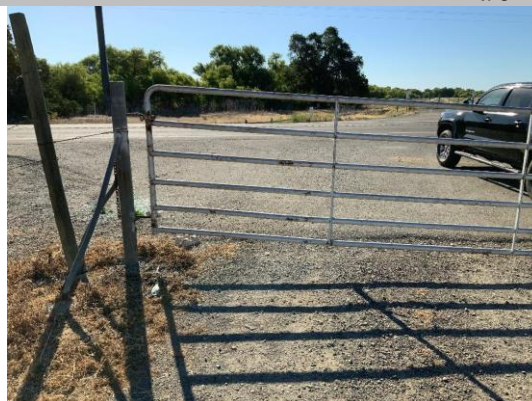
DS\_ID:19659  
 FS\_ID:67496  
 EP\_NO: N/A  
 Repair Type: Non-Urgent  
 EVAL Issue: Limited Inspection/No UCIP Evaluation  
 Crossing Status: Found  
 UCIP Comments: 06/8/2021 The record remains Non-Urgent. LS pipe inlet covered by trash and debris, recommend clearing out. No permit was found authorizing this encroachment. CVFPB will need to review crossing to determine owner. The UCIP inspection was completed with GEI staff, P. Espinoza. (H. Dunn – GEI) 05/01/2014 Dense vegetation limits the inspector's visibility to identify signs of pipe failure (leaks) along the slope. Recommend removing vegetation along pipe alignment to conduct proper inspection of structure. (O. Magana - DWR UCIP)  
 FIELD\_STRUCT\_DESC: 24-inch corrugated metal gravity drainage pipe through the levee, 7 feet below the crown. Flap gate on the waterside (WS) end. Brass cap No. 135 bench mark (BM) on the headwall on the landside (LS). [Additional Reference(s): DWR Levee Log, 2002 (HLM 2.32), listed as a 24-inch corrugated metal pipe (CMP). USACE San Joaquin O&M Manual, Unit 601 Part 1 (SJR 601.1), 1967, Revised 25 May 2011, (HLM 2.30), listed as a 24-inch CMP].

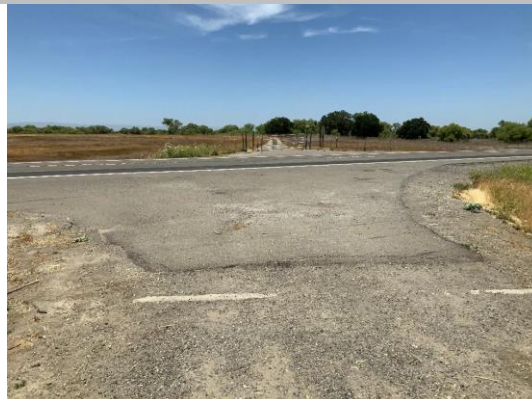
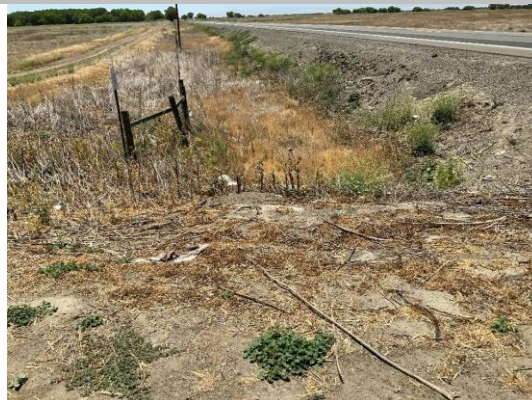
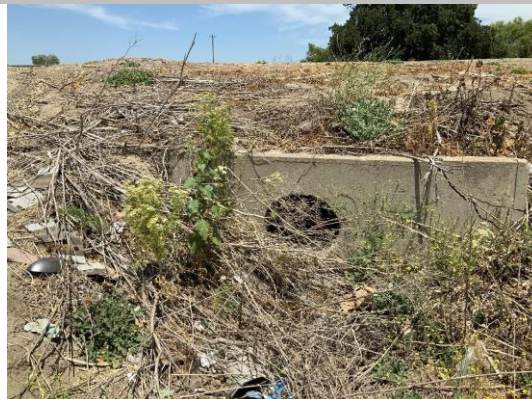
DS\_ID:19660  
FS\_ID:68226  
EP\_NO: N/A  
Repair Type: Non-Urgent  
EVAL Issue: Maintenance Compliance Issue  
Crossing Status: Found  
UCIP Comments: 06/8/2021 The record remains Non-Urgent.  
Vegetation present at pipe inlet on LS, recommend removal. No permit was found authorizing this encroachment. CVFPB will need to review crossing to determine owner. The UCIP inspection was completed with GEI staff, P. Espinoza. (H. Dunn ? GEI) 05/01/2014 Dense vegetation limits the inspector's visibility to identify signs of pipe failure (leaks) along the slope. Recommend removing vegetation along pipe alignment to conduct proper inspection of structure. (O. Magana - DWR UCIP)  
FIELD\_STRUCT\_DESC: 24-inch corrugated metal gravity drainage pipe through the levee, 7 feet below the crown. Flap gate on the waterside (WS) end. Brass cap No. 135 bench mark (BM) on the headwall on the landside (LS). [Additional Reference(s): DWR Levee Log, 2002 (HLM 2.34), listed as a 24-inch corrugated metal pipe (CMP). USACE San Joaquin O&M Manual, Unit 601 Part 1 (SJR 601.1), 1967, Revised 25 May 2011, (HLM 2.32), listed as a 24-inch CMP].

LS view: Slope and headwall at toe.

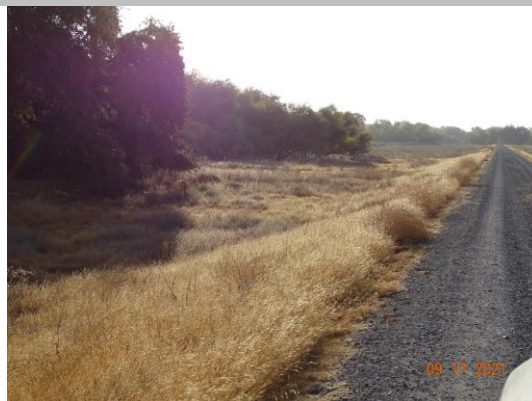
LM Start	2.32	Rating **	M	Issue No.	26
LM End	2.63	Issue Type +	Ma	Location *	WS
Category	Earthen Levee			GPS Latitude/Longitude	
				Start	End
Item	Vegetation			37.291404 °	37.288768 °
				-120.850953 °	-120.846533 °
DWR ID	DWR_NA0010_02A_f_2021_26				
Comment Code					
V1 : Control annual grass and weeds on the levee slopes and easements.					
Inspector Comment

View of the vegetation on the waterside slope. (Fall 2021)

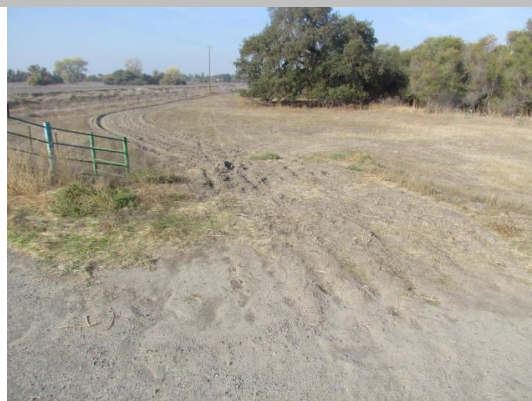
LM Start	2.32	Rating **	M	Issue No.	2
LM End	2.32	Issue Type +	En	Location *	LS
Category	Earthen Levee			GPS Latitude/Longitude	
				Start	End
Item	Encroachments			37.291433 °	37.291433 °
				-120.850917 °	-120.850917 °
DWR ID	DWR_NA0010_02A_s_2012_2				
Comment Code					
RA : Ramp					
Inspector Comment					
Unauthorized ramps are located on the landside and waterside slopes.

Looking northeast at unauthorized ramp on landward slope.

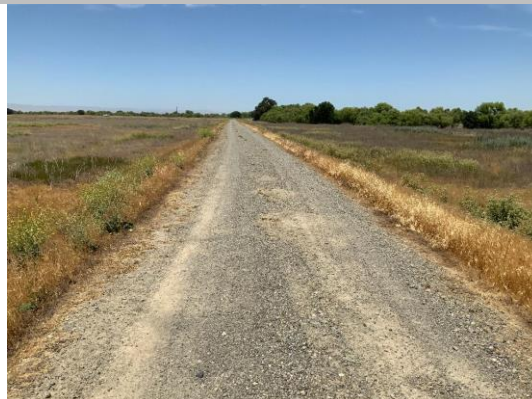
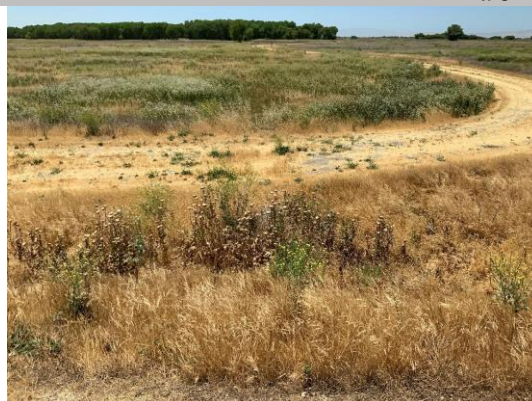
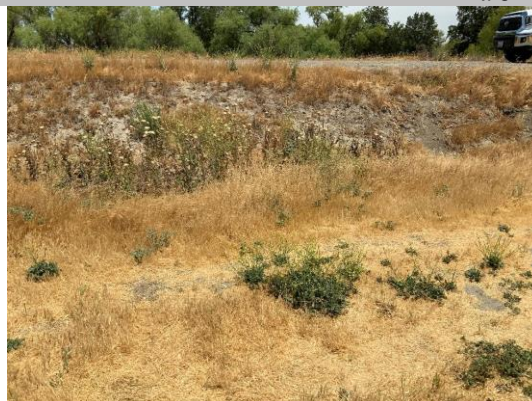
DS\_ID:19661  
FS\_ID:67629  
EP\_NO: N/A  
Repair Type: Non-Urgent  
EVAL Issue: Limited Inspection/No UCIP Evaluation  
Crossing Status: Found  
UCIP Comments: 06/8/2021 The record remains Non-Urgent.  
Vegetation on LS and WS limited close up inspection of flapgate and pipe inlet. No permit was found authorizing this encroachment. CVFPB will need to review crossing to determine owner. The UCIP inspection was completed with GEI staff, P. Espinoza. (H. Dunn – GEI)

05/01/2014 Dense vegetation limits the inspector's visibility to identify signs of pipe failure (leaks) along the slope. Recommend removing vegetation along pipe alignment to conduct proper inspection of structure. (O. Magana - DWR UCIP)  
FIELD\_STRUCT\_DESC: 24-inch corrugated metal gravity drainage pipe through the levee, 10 feet below the crown. Flap gate on the waterside (WS) end. Brass cap No. 130 bench mark (BM) on the headwall on the landside (LS). [Additional Reference(s): DWR Levee Log, 2002 (HLM 2.60), listed as a 24-inch corrugated metal pipe (CMP). USACE San Joaquin O&M Manual, Unit 601 Part 1 (SJR 601.1), 1967, Revised 25 May 2011, (HLM 2.59), listed as a 24-inch CMP].  
FS Date: 6/8/2021

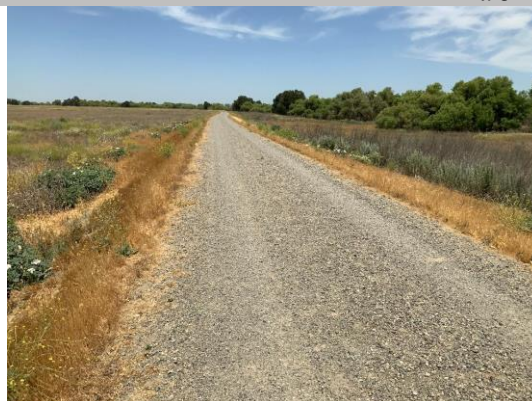
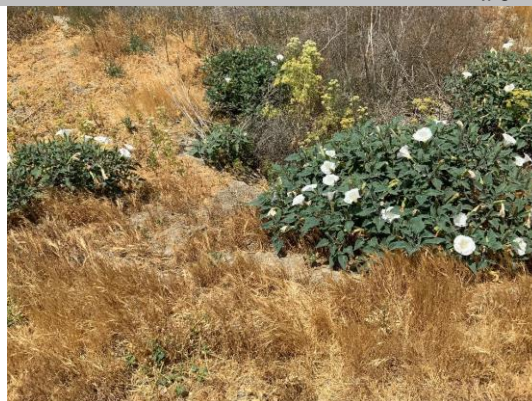
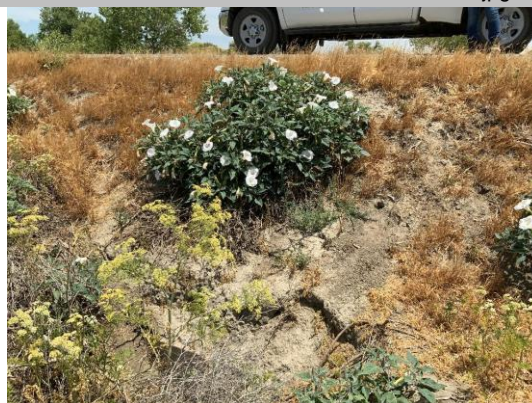
DS\_ID:19662  
 FS\_ID:67501  
 EP\_NO: N/A  
 Repair Type: Non-Urgent  
 EVAL Issue: Limited Inspection/No UCIP Evaluation  
 Crossing Status: Found  
 UCIP Comments: 06/7/2021 The record remains Non-Urgent. LS pipe inlet completely buried in sediment, recommend clearing out. No permit was found authorizing this encroachment. CVFPB will need to review crossing to determine owner. The UCIP inspection was completed with GEI staff, P. Espinoza. (H. Dunn – GEI) 05/01/2014 Dense vegetation limits the inspector's visibility to identify signs of pipe failure (leaks) along the slope. Recommend removing vegetation along pipe alignment to conduct proper inspection of structure. (O. Magana - DWR UCIP)  
 FIELD\_STRUCT\_DESC: 24-inch corrugated metal gravity drainage pipe through the levee, 10 feet below the crown. Flap gate on the waterside (WS) end. Brass cap No. 130 bench mark (BM) on the headwall on the landside (LS). [Additional Reference(s): DWR Levee Log, 2002 (HLM 2.97), listed as a 24-inch corrugated metal pipe (CMP). USACE San Joaquin O&M Manual, Unit 601 Part 1 (SJR 601.1), 1967, Revised 25 May 2011, (HLM 2.96), listed as a 24-inch CMP].

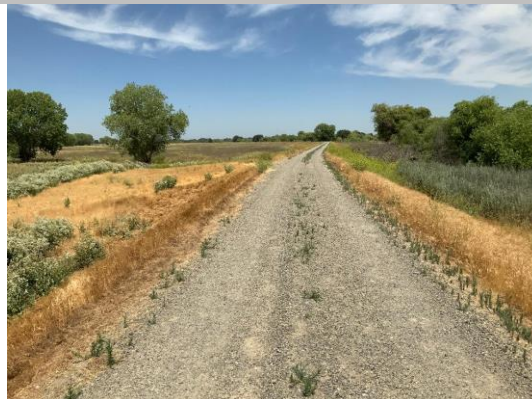
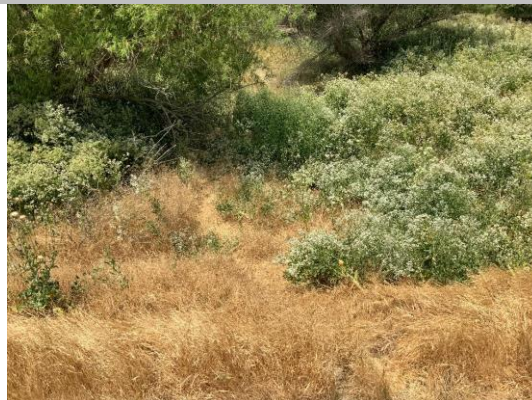
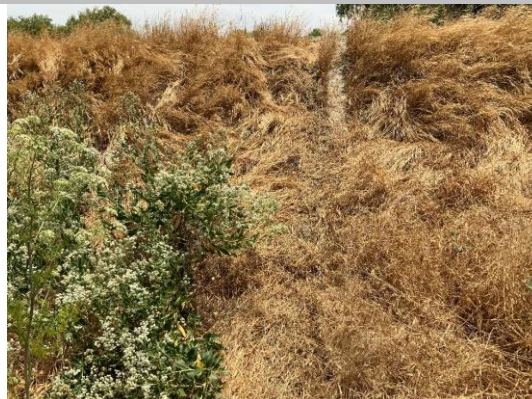
DS\_ID:19665  
FS\_ID:67502  
EP\_NO: N/A  
Repair Type: Non-Urgent  
EVAL Issue: Limited Inspection/No UCIP Evaluation  
Crossing Status: Found  
UCIP Comments: 06/7/2021 The record remains Non-Urgent. Dense vegetation limited view and inspection of LS pipe inlet. Recommend removal of LS vegetation. No permit was found authorizing this encroachment. CVFPB will need to review crossing to determine owner. The UCIP inspection was completed with GEI staff, P. Espinoza. (H. Dunn – GEI) 05/01/2014 Dense vegetation limits the inspector's visibility to identify signs of pipe failure (leaks) along the slope. Recommend removing vegetation along pipe alignment to conduct proper inspection of structure. (O. Magana - DWR UCIP)  
FIELD\_STRUCT\_DESC: 24-inch corrugated metal gravity drainage pipe through the levee, 12.4 feet below the crown. Flap gate on the waterside (WS) end. Brass cap No. 130 bench mark (BM) on the headwall on the landside (LS). [Additional Reference(s): DWR Levee Log, 2002 (HLM 3.31), listed as a 24-inch corrugated metal pipe (CMP). USACE San Joaquin O&M Manual, Unit 601 Part 1 (SJR 601.1), 1967, Revised 25 May 2011, (HLM 3.29), listed as a 24-inch CMP].

LS view: Toe from crown, pipe end not visible.

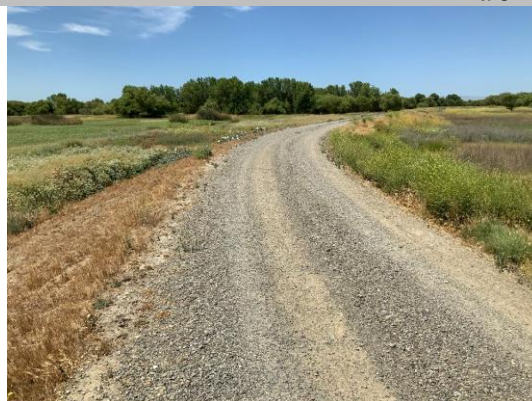
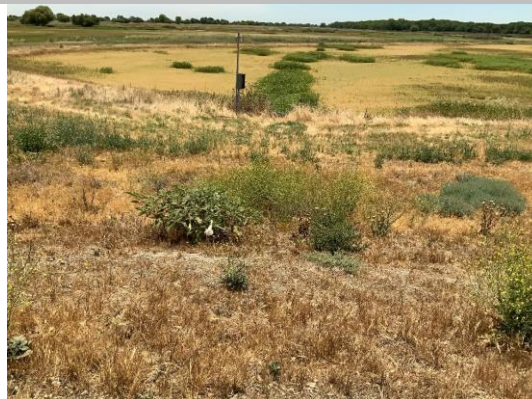
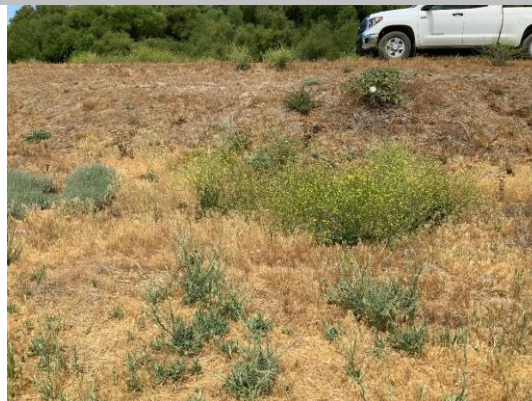
DS\_ID:19666  
FS\_ID:67503  
EP\_NO: N/A  
Repair Type: Non-Urgent  
EVAL Issue: Maintenance Compliance Issue  
Crossing Status: Found  
UCIP Comments: 06/7/2021 The record remains Non-Urgent. LS has boards blocking the open pipe inlet but there is significant sediment and vegetation on the other side of the boards, recommend cleaning around. No permit was found authorizing this encroachment. CVFPB will need to review crossing to determine owner. The UCIP inspection was completed with GEI staff, P. Espinoza. (H. Dunn – GEI)

FIELD\_STRUCT\_DESC: 24-inch corrugated metal gravity drainage pipe through the levee, 10 feet below the crown. Flap gate on the waterside (WS) end. Brass cap No. 130 bench mark (BM) on the headwall on the landside (LS). [Additional Reference(s): DWR Levee Log, 2002 (HLM 3.63), listed as a 24-inch corrugated metal pipe (CMP). USACE San Joaquin O&M Manual, Unit 601 Part 1 (SJR 601.1), 1967, Revised 25 May 2011, (HLM 3.62), listed as a 24-inch CMP].  
FS Date: 6/7/2021

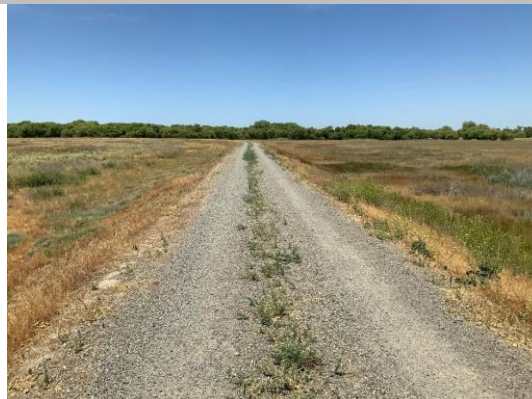
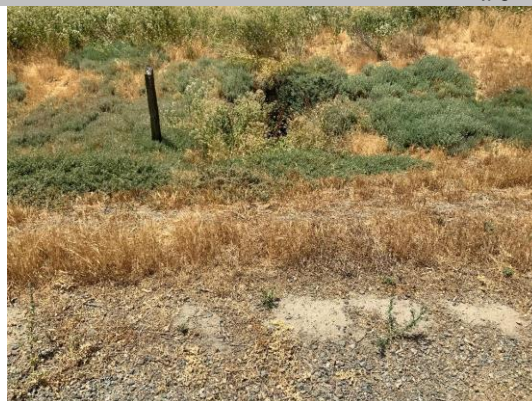
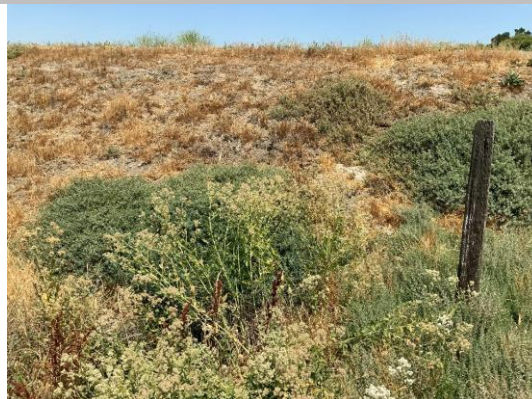
DS\_ID:19667  
FS\_ID:67504  
EP\_NO: N/A  
Repair Type: Non-Urgent  
EVAL Issue: Limited Inspection/No UCIP Evaluation  
Crossing Status: Found  
UCIP Comments: 06/7/2021 The record remains Non-Urgent. Dense vegetation around LS pipe inlet, recommend removal. No permit was found authorizing this encroachment. CVFPB will need to review crossing to determine owner. The UCIP inspection was completed with GEI staff, P. Espinoza. (H. Dunn – GEI) 05/01/2014 Signs of erosion or sink hole present on landward toe--Need to contact owner. Dense vegetation limits the inspector's visibility to identify signs of pipe failure (leaks) along the slope. Recommend removing vegetation along pipe alignment to conduct proper inspection of structure. (O. Magana - DWR UCIP)  
FIELD\_STRUCT\_DESC: 24-inch corrugated metal gravity drainage pipe through the levee, 8.6 feet below the crown. Flap gate on the waterside (WS) end. Brass cap No. 130 bench mark (BM) on the headwall on the landside (LS). [Additional Reference(s): DWR Levee Log, 2002 (HLM 3.96), listed as a 24-inch corrugated metal pipe (CMP). USACE San Joaquin O&M Manual, Unit 601 Part 1 (SJR 601.1), 1967, Revised 25 May 2011, (HLM 3.95), listed as a 24-inch CMP].

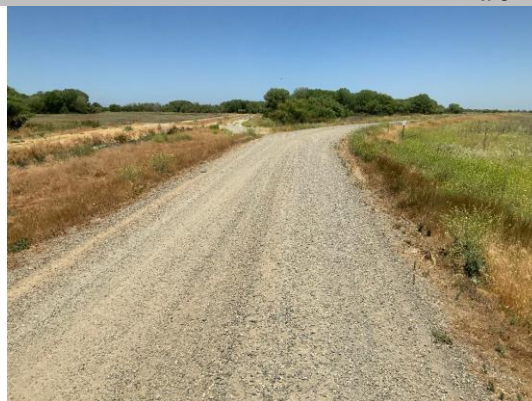
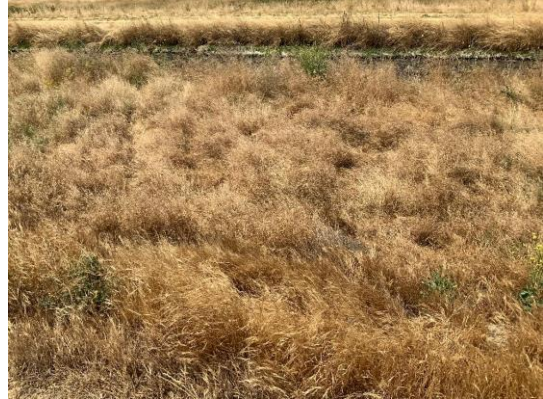
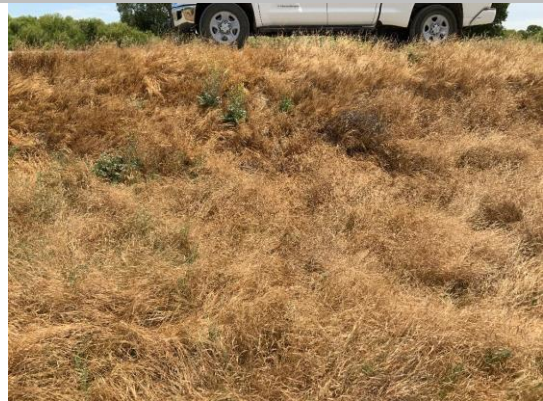
Photo 1 of 3 : UCIP\_FA\_2021\_67505\_100159.jpg

DS\_ID:19668  
 FS\_ID:67505  
 EP\_NO: N/A  
 Repair Type: Non-Urgent  
 EVAL Issue: Limited Inspection/No UCIP Evaluation  
 Crossing Status: Found  
 UCIP Comments: 06/7/2021 The record remains Non-Urgent. Limited inspection on WS due to dense vegetation, flapgate not visible, recommend clearing away. Limited inspection on LS due to canal limiting access to inlet. No permit was found authorizing this encroachment. CVFPB will need to review crossing to determine owner. The UCIP inspection was completed with GEI staff, P. Espinoza. (H. Dunn – GEI) 05/01/2014 Dense vegetation limits the inspector's visibility to identify signs of pipe failure (leaks) along the slope. Recommend removing vegetation along pipe alignment to conduct proper inspection of structure. (O. Magana - DWR UCIP)  
 FIELD\_STRUCT\_DESC: 24-inch corrugated metal gravity drainage pipe through the levee, 8 feet below the crown. Flap gate on the waterside (WS) end. Brass cap No. 125 bench mark (BM) on the headwall on the landside (LS). [Additional Reference(s): DWR Levee Log, 2002 (HLM 5.45), listed as a 24-inch corrugated metal pipe (CMP). USACE San Joaquin O&M Manual, Unit 601 Part 1 (SJR 601.1), 1967, Revised 25 May 2011, (HLM 5.43), listed as a 24-inch CMP].

Levee crown looking downstream.

LS view: Toe from crown.

LS view: Slope from toe.

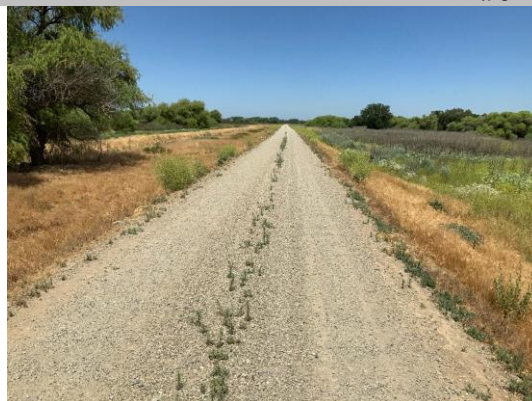
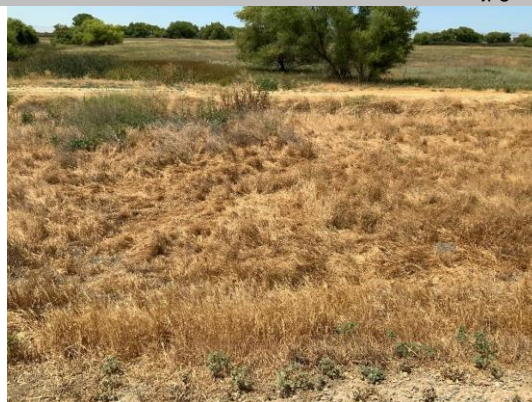
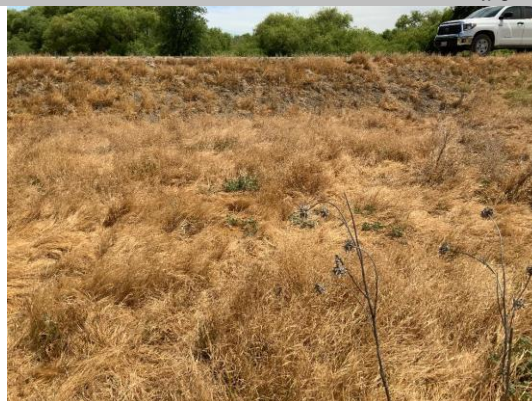
Photo 1 of 3 : UCIP\_FA\_2021\_67506\_100164.jpg

Comment Code					
Inspector Comment					
DS_ID:19669 FS_ID:67506 EP_NO: N/A Repair Type: Non-Urgent EVAL Issue: Limited Inspection/No UCIP Evaluation Crossing Status: Found UCIP Comments: 06/7/2021 The record remains Non-Urgent. LS pipe inlet completely buried under sediment, recommend clearing out. No permit was found authorizing this encroachment. CVFPB will need to review crossing to determine owner. The UCIP inspection was completed with GEI staff, P. Espinoza. (H. Dunn – GEI) 05/01/2014 Dense vegetation limits the inspector's visibility to identify signs of pipe failure (leaks) along the slope. Recommend removing vegetation along pipe alignment to conduct proper inspection of structure. (O. Magana - DWR UCIP) FIELD_STRUCT_DESC: 24-inch corrugated metal gravity drainage pipe through the levee, 7.7 feet below the crown. Flap gate on the waterside (WS) end. Brass cap No. 125 bench mark (BM) on the headwall on the landside (LS). [Additional Reference(s): DWR Levee Log, 2002 (HLM 6.06), listed as a 24-inch corrugated metal pipe (CMP). USACE San Joaquin O&M Manual, Unit 601 Part 1 (SJR 601.1), 1967, Revised 25 May 2011, (HLM 6.06), listed as a 24-inch CMP]. FS Date: 6/7/2021

Levee crown looking downstream.

LS view: Toe from crown.

LS view: Slope from toe.

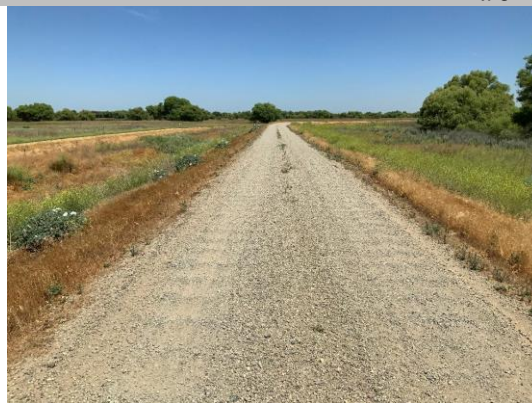
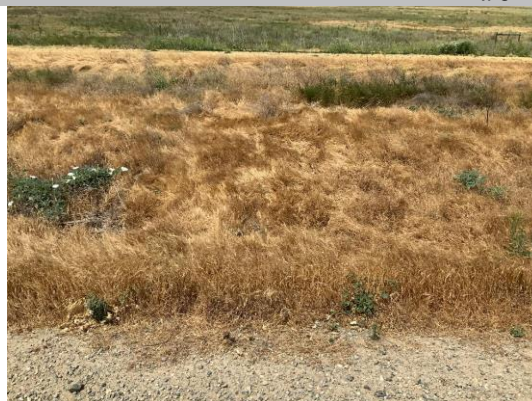
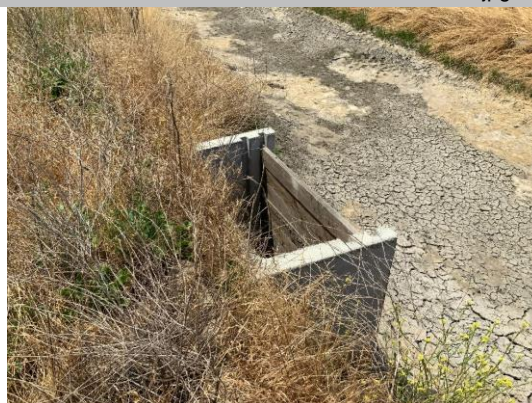
Photo 1 of 3 : UCIP\_FA\_2021\_67630\_100173.jpg

DS\_ID:19670  
 FS\_ID:67630  
 EP\_NO: N/A  
 Repair Type: Non-Urgent  
 EVAL Issue: Limited Inspection/No UCIP Evaluation  
 Crossing Status: Found  
 UCIP Comments: 06/7/2021 The record remains Non-Urgent. Limited inspection on LS due to canal and inability to access. No permit was found authorizing this encroachment. CVFPB will need to review crossing to determine owner. The UCIP inspection was completed with GEI staff, P. Espinoza. (H. Dunn – GEI) 05/01/2014 Dense vegetation limits the inspector's visibility to identify signs of pipe failure (leaks) along the slope. Recommend removing vegetation along pipe alignment to conduct proper inspection of structure. (O. Magana - DWR UCIP)  
 FIELD\_STRUCT\_DESC: 24-inch corrugated metal gravity drainage pipe through the levee, 7.7 feet below the crown. Flap gate on the waterside (WS) end. Brass cap No. 125 bench mark (BM) on the headwall on the landside (LS). [Additional Reference(s): DWR Levee Log, 2002 (HLM 6.50), listed as a 24-inch corrugated metal pipe (CMP). USACE San Joaquin O&M Manual, Unit 601 Part 1 (SJR 601.1), 1967, Revised 25 May 2011, (HLM 6.50), listed as a 24-inch CMP].

Levee crown looking downstream.

LS view: Toe from crown.

LS view: Close up of concrete box and pipe inlet.

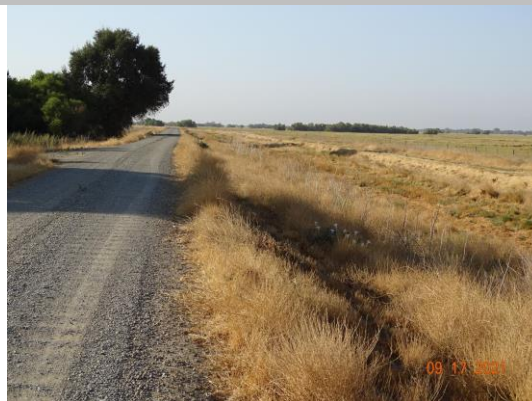
Photo 1 of 1 : FA\_2021\_NA0010\_119\_29\_20210927\_00071.jpg

LM Start	6.48	Rating **	M	Issue No.	29
LM End	6.60	Issue Type +	Ma	Location *	LS
Category	Earthen Levee			GPS Latitude/Longitude	
				Start	End
Item	Vegetation			37.248006 °	37.246283 °
				-120.823124 °	-120.822924 °
DWR ID	DWR_NA0010_02A_f_2021_29				
Comment Code					
V1 : Control annual grass and weeds on the levee slopes and easements.					
Inspector Comment

Looking at annual vegetation growing along the landside slope. (Fall 2021)

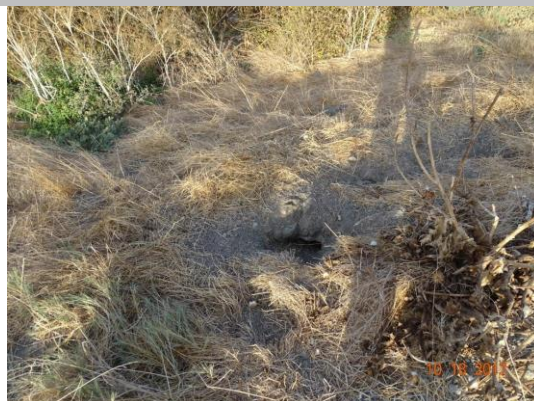
Photo 1 of 1 : FA\_2021\_NA0010\_119\_28\_20210830\_00007.jpg

LM Start	6.97	Rating **	A/W	Issue No.	28
LM End	6.97	Issue Type +	Ma	Location *	LS
Category	Earthen Levee			GPS Latitude/Longitude	
				Start	End
Item	Animal Control			37.241125 °	37.241125 °
				-120.821747 °	-120.821747 °
DWR ID	DWR_NA0010_02A_f_2017_28				
Comment Code					
A3 : No rodents visible, but rodent burrows visible; need to backfill and compact or grout burrows.					
Inspector Comment

Looking northwest at landside slope.

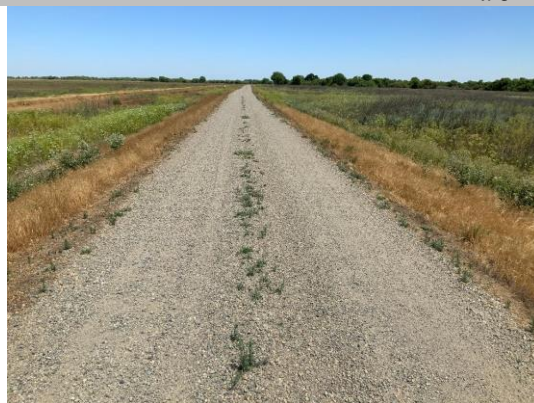
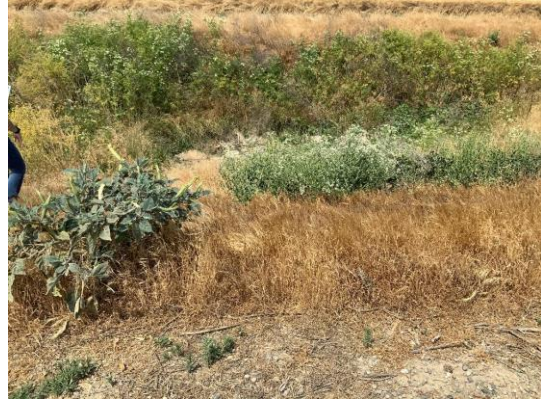
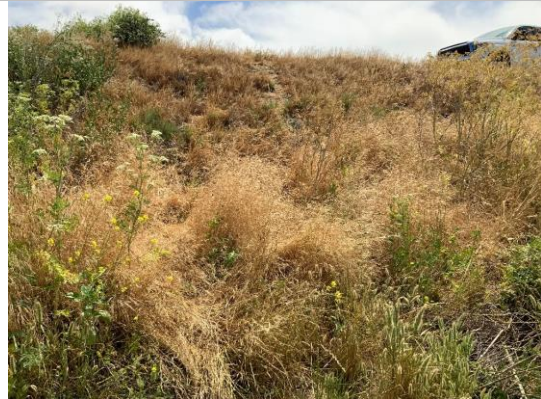
Photo 1 of 3 : UCIP\_FA\_2021\_67508\_100180.jpg

Comment Code					
Inspector Comment					
DS_ID:19671 FS_ID:67508 EP_NO: N/A Repair Type: Non-Urgent EVAL Issue: Limited Inspection/No UCIP Evaluation Crossing Status: Found UCIP Comments: 06/7/2021 The record remains Non-Urgent. Dense vegetation on WS limited inspection. LS pipe inlet is completely buried under sediment, recommend cleaning out. No permit was found authorizing this encroachment. CVFPB will need to review crossing to determine owner. The UCIP inspection was completed with GEI staff, P. Espinoza. (H. Dunn – GEI) 05/01/2014 Dense vegetation limits the inspector's visibility to identify signs of pipe failure (leaks) along the slope. Recommend removing vegetation along pipe alignment to conduct proper inspection of structure. Pipe extension visible on landward side--need to contact owner for additional information about extension/modification. (O. Magana - DWR UCIP) FIELD_STRUCT_DESC: 24-inch corrugated metal gravity drainage pipe through the levee, 12.6 feet below the crown. Flap gate on the waterside (WS) end. Brass cap No. 125 bench mark (BM) on the headwall on the landside (LS). [Additional Reference(s): DWR Levee Log, 2002 (HLM 7.06), listed as a 24-inch corrugated metal pipe (CMP). USACE San Joaquin O&M Manual, Unit 601 Part 1 (SJR 601.1), 1967, Revised 25 May 2011, (HLM 7.05), listed as a 24-inch CMP]. FS Date: 6/7/2021

Levee crown looking downstream.

LS view: Toe from crown.

LS view: Slope from toe.

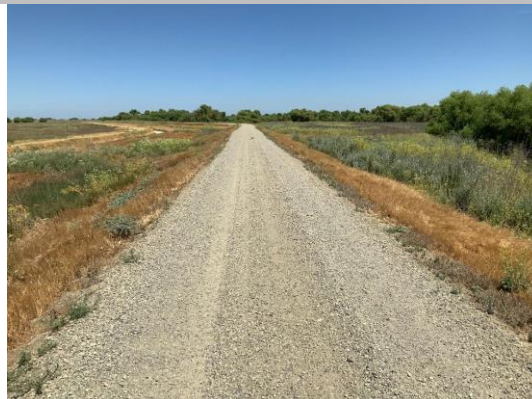
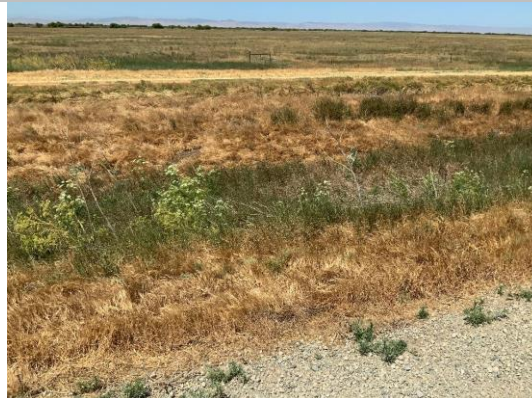
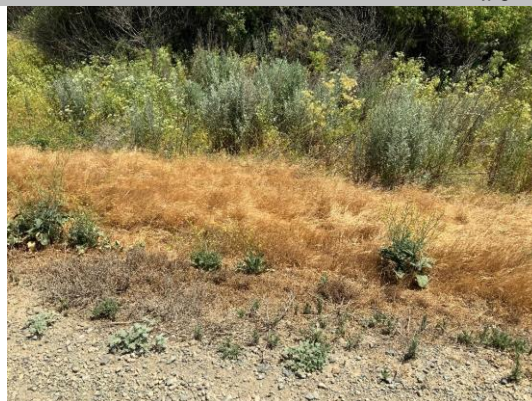
Photo 1 of 3 : UCIP\_FA\_2021\_67509\_100185.jpg

LM Start	7.45	Rating **	M	Issue No.	48	
LM End	7.45	Issue Type +	En	Location *		
Category	Supplemental			GPS Latitude/Longitude		
				Start		End
Item	DWR UCIP Field Study			37.235448 °	37.235448 °	
				-120.816862 °	-120.816862 °	
DWR ID	19672					
Comment Code						
Inspector Comment						
DS_ID:19672 FS_ID:67509 EP_NO: N/A Repair Type: Non-Urgent EVAL Issue: Pipe Not Found Crossing Status: Not Found UCIP Comments: 06/7/2021 The record is Non-Urgent. Pipe not found by visual inspection. No permit was found authorizing this encroachment. CVFPB will need to review crossing to determine owner. The UCIP inspection was completed with GEI staff, P. Espinoza. (H. Dunn – GEI) FIELD_STRUCT_DESC: 4-inch aluminum pipe of an unknown purpose through the levee, 0.333 feet below the crown. [Additional Resource(s): DWR Levee Logs, 2002 (HLM 7.48), listed as a 4-inch pipe] FS Date: 6/7/2021

Levee crown looking downstream.

LS view: Toe from crown, no pipe visible.

WS view: Toe from crown, no pipe visible.

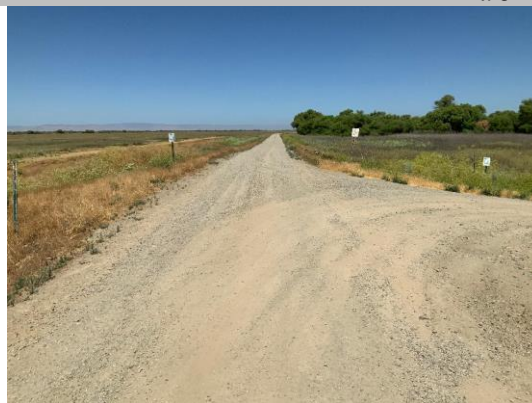
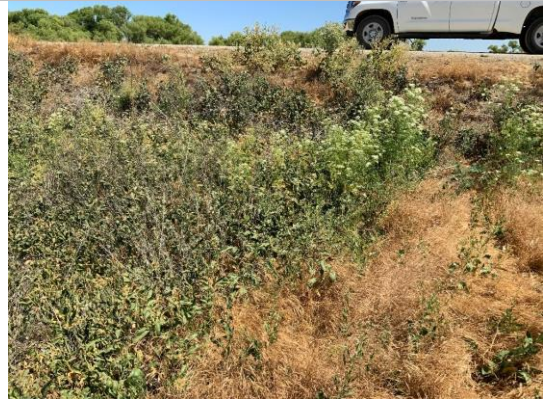
Photo 1 of 3 : UCIP\_FA\_2021\_68455\_100189.jpg

DS\_ID:19673  
 FS\_ID:68455  
 EP\_NO: N/A  
 Repair Type: Non-Urgent  
 EVAL Issue: Limited Inspection/No UCIP Evaluation  
 Crossing Status: Found  
 UCIP Comments: 06/7/2021 The record remains Non-Urgent. LS pipe end not visible, dense vegetation on both WS and LS ends, recommend removal. No permit was found authorizing this encroachment. CVFPB will need to review crossing to determine owner. The UCIP inspection was completed with GEI staff, P. Espinoza. (H. Dunn – GEI)05/01/2014 Dense vegetation limits the inspector's visibility to identify signs of pipe failure (leaks) along the slope. Recommend removing vegetation along pipe alignment to conduct proper inspection of structure. (O. Magana - DWR UCIP)  
 FIELD\_STRUCT\_DESC: 24-inch corrugated metal gravity drainage pipe through the levee, 8 feet below the crown. Flap gate on the waterside (WS) end. Brass cap No. 125 bench mark (BM) on the headwall on the landside (LS). [Additional Reference(s): DWR Levee Log, 2002 (HLM 7.78), listed as a 24-inch corrugated metal pipe (CMP). USACE San Joaquin O&M Manual, Unit 601 Part 1 (SJR 601.1), 1967, Revised 25 May 2011, (HLM 7.77), listed as a 24-inch CMP].

Levee crown looking downstream.

LS view: Headwall and inlet not visible under vegetation.

LS view: Slope from toe.
