## Flood Control Project Maintenance Levee Inspections

### Fall 2021 Levee Maintenance Deficiency Summary Report

#### San Joaquin River Basin

NA0010 Lower San Joaquin Levee District	Overall LMA Rating	Total LMA Miles							
	U	191.27							
Rated Item	Maintenance Deficiency				Enforcement		Design & System Obsolescence		
	M Miles	U Miles	M + 4U Miles	Threshold %	M Miles	U Miles	M Miles	U Miles	
<i>Earthen Levee</i>									
Vegetation	47.00	9.57	85.28	44.59%					
Trim / Thin Trees	0.10		0.10	0.05%					
Encroachments	0.23	0.02	0.31	0.16%	9.29	0.59			
Animal Control	7.67	2.19	16.43	8.59%					
Slope Stability	0.05	0.01	0.09	0.05%					
Erosion / Bank Caving	0.13	0.81	3.37	1.76%					
Crown Surface / Depressions / Rutting	0.01		0.01	0.01%					
Repair Gates	0.02	0.02	0.10	0.05%					
<i>Rivers, Channels &amp; Designated Floodways</i>									
Encroachments					0.01	0.01			
<i>Supplemental</i>									
DWR Erosion Survey	0.12	0.17	0.80	0.42%					
DWR UCIP Field Study					1.29	0.05			
DWR UCIP LMA Responsibility									
<i>LMA Totals:</i>	55.33	12.79	106.49	55.67%	10.59	0.65	0.00	0.00

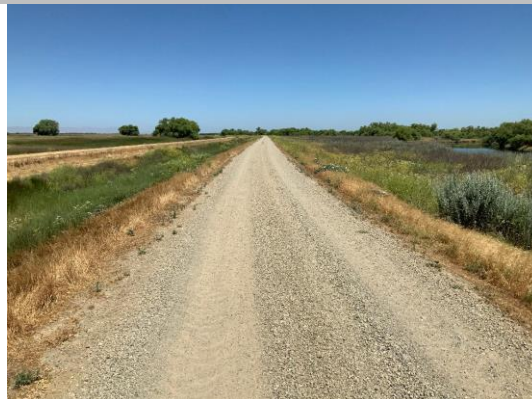
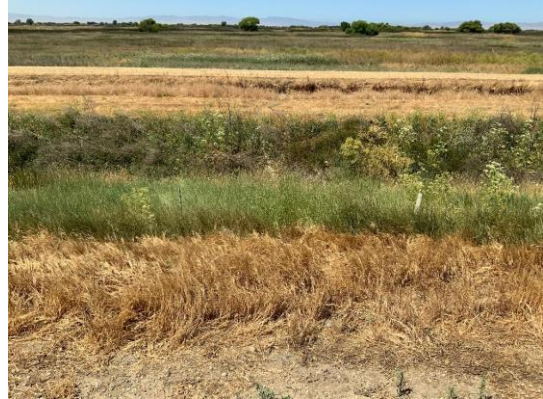
Photo 1 of 3 : UCIP\_FA\_2021\_68227\_100048.jpg

Comment Code						
Inspector Comment						
DS_ID:19674 FS_ID:68227 EP_NO: N/A Repair Type: Non-Urgent EVAL Issue: Limited Inspection/No UCIP Evaluation Crossing Status: Found UCIP Comments: 06/7/2021 Record remains Non-Urgent. DWR DMP internal inspection has not found pipe integrity issues. LOF of crossing is less or equal to 4.0. Recommend next video inspection in 5 years. LS headwall barely visible at toe due to dense vegetation. Dense vegetation also over WS flapgate. Limited inspection of both WS and LS pipe ends. Recommend removal of vegetation on both WS and LS. No permit was found authorizing this encroachment. CVFPB will need to review crossing to determine owner. The UCIP inspection was completed with GEI staff, P. Espinoza. (H. Dunn – GEI) 05/14/2014 Dense vegetation limits the inspector's visibility to identify signs of pipe failure (leaks) along the slope and landward headwall. Recommend removing vegetation along pipe alignment and toe to conduct proper inspection of structure. Sediment buildup in pipe visible from landward side--recommend clearing. (O. Magana - DWR UCIP) FIELD_STRUCT_DESC: 24-inch corrugated metal gravity drainage pipe through the levee, 9 feet below the crown. Flap gate on the waterside (WS) end. Brass cap No. 120 bench mark (BM) on the headwall on the landside (LS). [Additional Reference(s): DWR Levee Log, 2002 (HLM 8.17), listed as a 24-inch corrugated metal pipe (CMP). USACE San Joaquin O&M Manual, Unit 601 Part 1 (SJR 601.1), 1967, Revised 25 May 2011, (HLM 8.16), listed as a 24-inch CMP]. FS Date: 6/7/2021

Levee crown looking downstream.

LS view: Slope from crown.

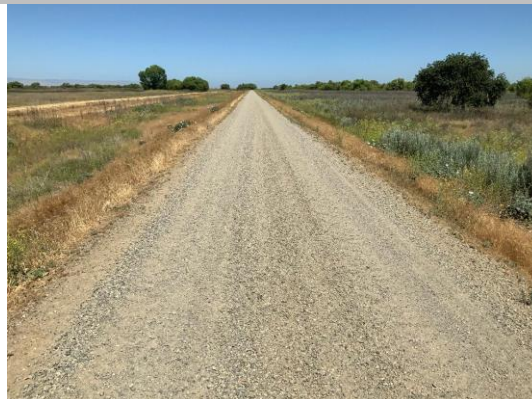
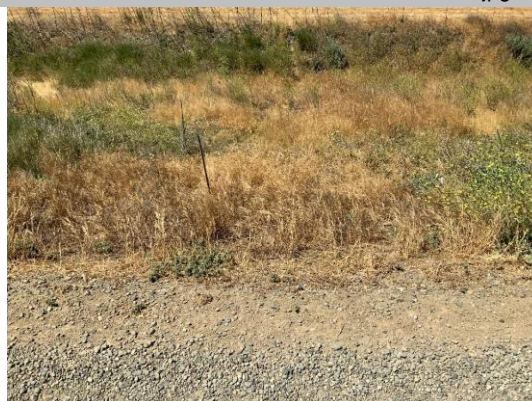
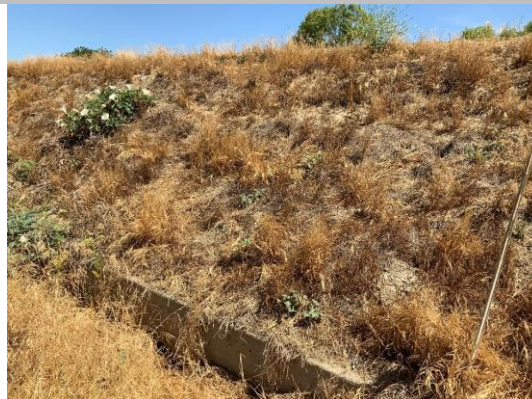
Photo 1 of 3 : UCIP\_FA\_2021\_67607\_100340.jpg

DS\_ID:19675  
FS\_ID:67607  
EP\_NO: N/A  
Repair Type: Non-Urgent  
EVAL Issue: Limited Inspection/No UCIP Evaluation  
Crossing Status: Found  
UCIP Comments: 06/7/2021 The record remains Non-Urgent. LS pipe inlet completely buried in dense vegetation, only top of headwall visible. Dense vegetation above WS flapgate. Limited inspection of pipe ends, recommend vegetation removal on both sides. No permit was found authorizing this encroachment. CVFPB will need to review crossing to determine owner. The UCIP inspection was completed with GEI staff, P. Espinoza. (H. Dunn – GEI) 05/14/2014 Dense vegetation on landward toe. Also dense vegetation limits the inspector's visibility to identify signs of pipe failure (leaks) along waterward slope. Recommend removing vegetation along pipe alignment toe to conduct proper inspection of structure. Sediment buildup in pipe--recommend clearing. (O. Magana - DWR UCIP)

Levee crown looking downstream.

LS view: Toe and slope from crown.

LS view: Slope from toe, top of headwall visible.

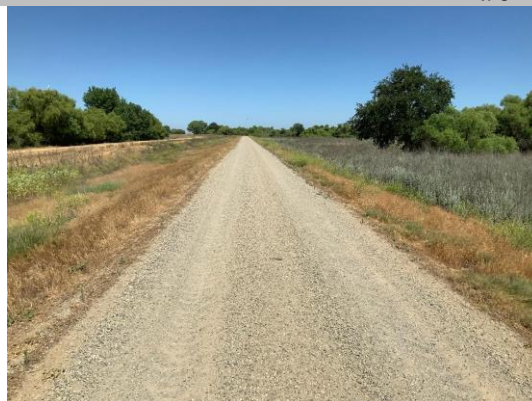
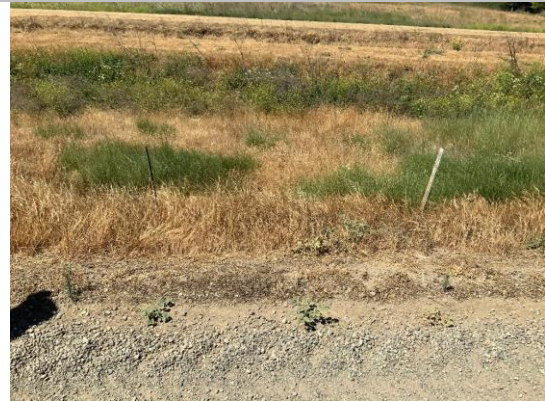
Photo 1 of 3 : UCIP\_FA\_2021\_68228\_100347.jpg

DS\_ID:19676  
 FS\_ID:68228  
 EP\_NO: N/A  
 Repair Type: Non-Urgent  
 EVAL Issue: Maintenance Compliance Issue  
 Crossing Status: Found  
 UCIP Comments: 06/7/2021 The record remains Non-Urgent. DWR DMP internal inspection has not found pipe integrity issues. LOF of crossing is less or equal to 4.0. Recommend next video inspection in 5 years. Dense vegetation around LS pipe end, recommend removal. No permit was found authorizing this encroachment. CVFPB will need to review crossing to determine owner. The UCIP inspection was completed with GEI staff, P. Espinoza. (H. Dunn – GEI) 05/14/2014 Dense vegetation limits the inspector's visibility to identify signs of pipe failure (leaks) along the slope. Recommend removing vegetation along pipe alignment to conduct proper inspection of structure. Burrow activity present on waterward slope. (O. Magana - DWR UCIP)  
 FIELD\_STRUCT\_DESC: 24-inch corrugated metal gravity drainage pipe through the levee, 8.8 feet below the crown. Flap gate on the waterside (WS) end. Brass cap No. 120 bench mark (BM) on the headwall on the landside (LS). [Additional Reference(s): DWR Levee Log, 2002 (HLM 8.88), listed as a 24-inch corrugated metal pipe (CMP). USACE San Joaquin O&M Manual, Unit 601 Part 1 (SJR 601.1), 1967, Revised 25 May 2011, (recorded as HLM 9.86 should be HLM 8.86), listed as a 24-inch CMP].

Levee crown looking downstream.

LS view: Toe from crown.

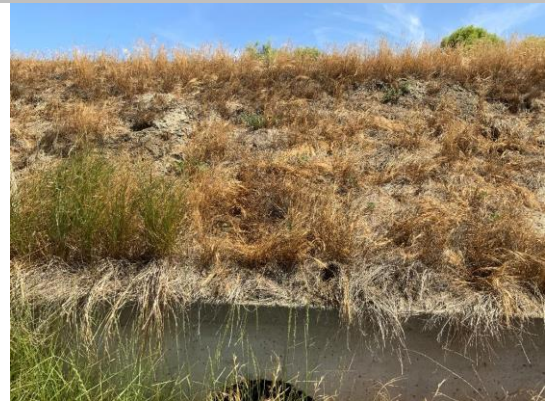
Photo 3 of 3 : UCIP\_FA\_2021\_68228\_100349.jpg

LS view: Slope above headwall from toe.

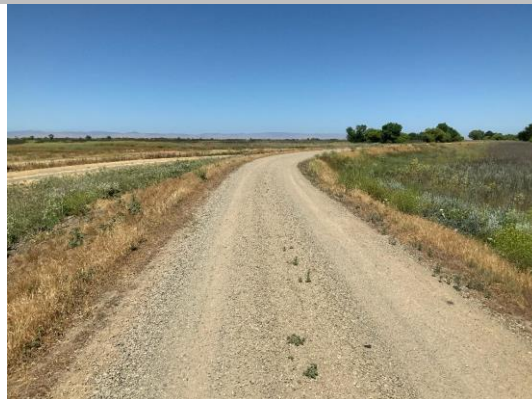
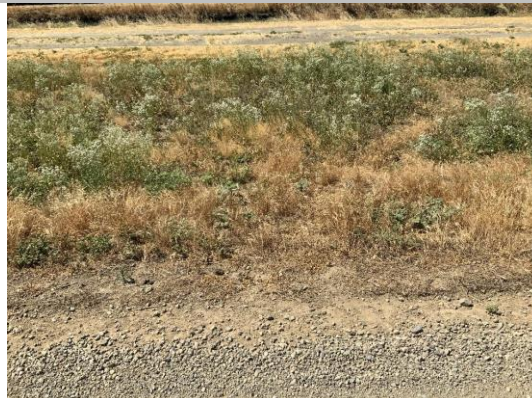
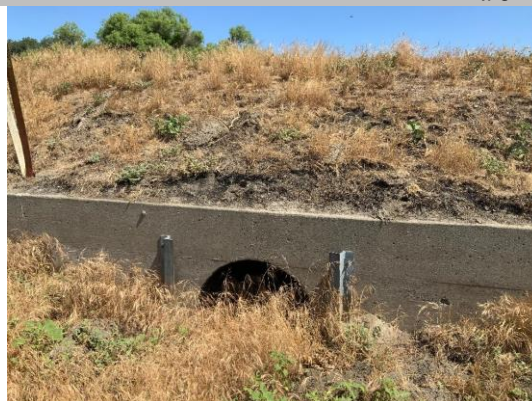
LM Start	<b>9.00</b>	Rating **	M	Issue No.	<b>31 (cont)</b>
LM End	<b>9.00</b>	Issue Type +	Ma	Location *	
Category	Supplemental		GPS Latitude/Longitude		
			Start	End	
Item	DWR UCIP LMA Responsibility		37.220888 °	37.220888 °	
			-120.796394 °	-120.796394 °	
DWR ID	19677

Comment Code					
Inspector Comment					
DS_ID:19677 FS_ID:67610 EP_NO: N/A Repair Type: Non-Urgent EVAL Issue: Unauthorized Encroachment, installed decades prior Crossing Status: Found UCIP Comments: 06/7/2021 The record remains Non-Urgent. No permit was found authorizing this encroachment. CVFPB will need to review crossing to determine owner. Minor vegetation over LS pipe inlet. The UCIP inspection was completed with GEI staff, P. Espinoza. (H. Dunn ? GEI) 05/14/201 Dense vegetation limits the inspector's visibility to identify signs of pipe failure (leaks) along the slope. Recommend removing vegetation along pipe alignment to conduct proper inspection of structure. (O. Magana - DWR UCIP) FIELD_STRUCT_DESC: 36-inch corrugated metal gravity drainage pipe through the levee, 8.8 feet below the crown. Flap gate on the waterside (WS) end. Brass cap No. 120 bench mark (BM) on the headwall on the landside (LS). [Additional Reference(s): DWR Levee Log, 2002 (HLM 9.03), listed as a 36-inch corrugated metal pipe (CMP). USACE San Joaquin O&M Manual, Unit 601 Part 1 (SJR 601.1), 1967, Revised 25 May 2011, (HLM 9.02), listed as a 36-inch CMP]. FS Date: 6/7/2021

Levee crown looking downstream.

LS view: Toe from crown.

LS view: Slope and headwall at toe.

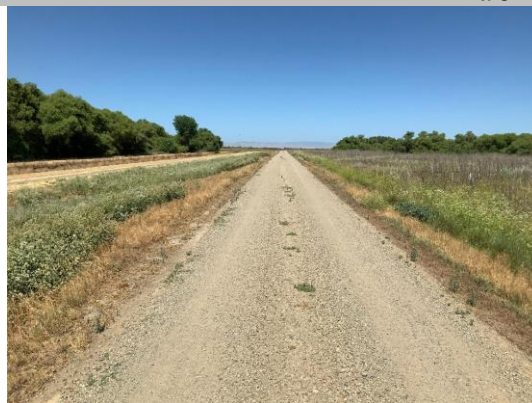
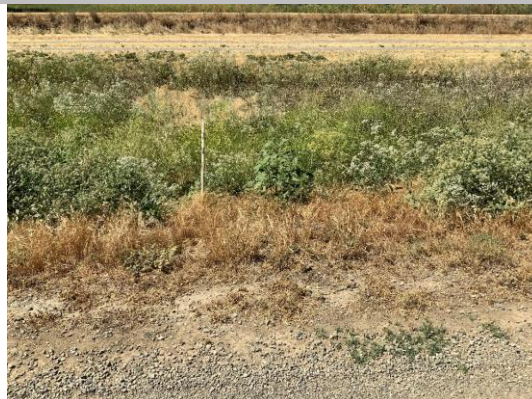
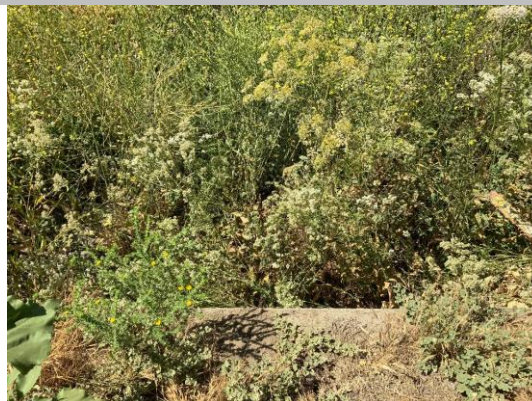
LM Start	<b>9.17</b>	Rating **	M	Issue No.	<b>32 (cont)</b>
LM End	<b>9.17</b>	Issue Type +	Ma	Location *	
Category	Supplemental			GPS Latitude/Longitude	
				Start	End
Item	DWR UCIP LMA Responsibility			37.220520 °	37.220520 °
				-120.793277 °	-120.793277 °
DWR ID	19678

DS\_ID:19678  
 FS\_ID:67611  
 EP\_NO: N/A  
 Repair Type: Non-Urgent  
 EVAL Issue: Limited Inspection/No UCIP Evaluation  
 Crossing Status: Found  
 UCIP Comments: 06/7/2021 The record remains Non-Urgent. DWR DMP internal inspection has not found pipe integrity issues. LOF of crossing is less or equal to 4.0. Recommend next video inspection in 5 years. Dense vegetation over LS pipe inlet limited inspection, recommend removal. No permit was found authorizing this encroachment. CVFPB will need to review crossing to determine owner. The UCIP inspection was completed with GEI staff, P. Espinoza. (H. Dunn – GEI) 05/14/2014 Dense vegetation limits the inspector's visibility to identify signs of pipe failure (leaks) along the slope. Recommend removing vegetation along pipe alignment to conduct proper inspection of structure. (O. Magana - DWR UCIP)  
 FIELD\_STRUCT\_DESC: 24-inch corrugated metal gravity drainage pipe through the levee, 8 feet below the crown. Flap gate on the waterside (WS) end. Brass cap No. 120 bench mark (BM) on the headwall on the landside (LS). [Additional Reference(s): DWR Levee Log, 2002 (HLM 9.21), listed as a 24-inch corrugated metal pipe (CMP). USACE San Joaquin O&M Manual, Unit 601 Part 1 (SJR 601.1), 1967, Revised 25 May 2011, (HLM 9.20), listed as a 24-inch CMP].

Levee crown looking downstream.

LS view: Toe from crown.

LS view: Top of headwall visible, pipe inlet covered with dense vegetation.

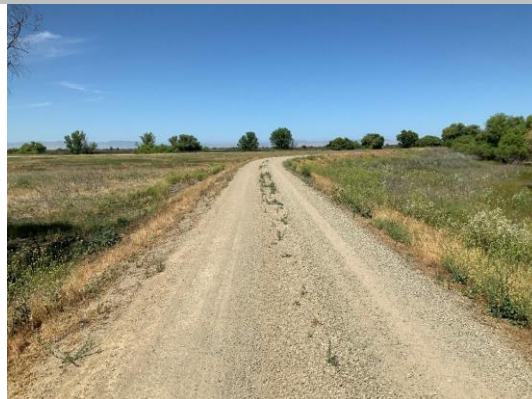
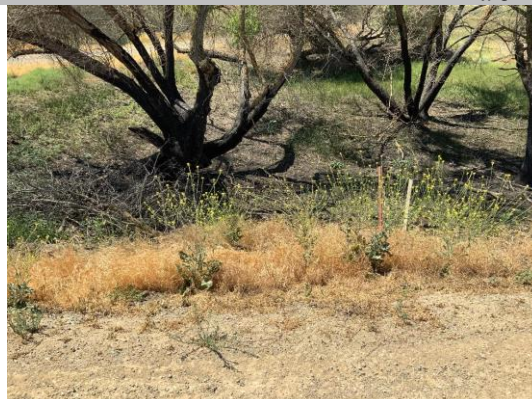
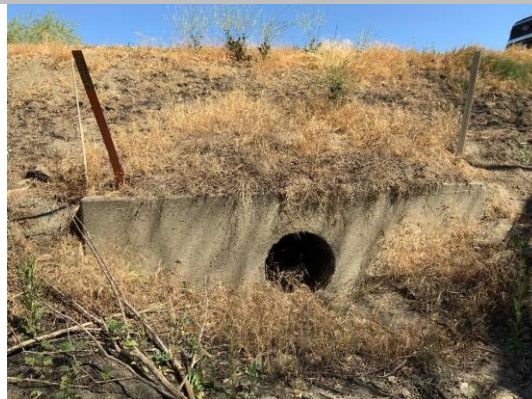
LM Start	<b>9.43</b>	Rating **	U	Issue No.	<b>33 (cont)</b>
LM End	<b>9.43</b>	Issue Type +	Ma	Location *	
Category	Supplemental		GPS Latitude/Longitude		
			Start	End	
Item	DWR UCIP LMA Responsibility		37.220227 °	37.220227 °	
			-120.788634 °	-120.788634 °	
DWR ID	19686

DS\_ID:19686  
FS\_ID:68229  
EP\_NO: N/A  
Repair Type: Urgent  
EVAL Issue: Pipe Integrity  
Crossing Status: Found  
UCIP Comments: 06/7/2021 The record has been upgraded from Non-Urgent to Urgent. DWR DMP internal inspection has found pipe integrity issues. LOF of crossing is greater than or equal to 5.0. Crossing will be monitored until funding becomes available to address the issues. Some rusting and peeling of liner inside LS pipe inlet. No permit was found authorizing this encroachment. CVFPB will need to review crossing to determine owner. The UCIP inspection was completed with GEI staff, P. Espinoza. (H. Dunn – GEI)05/14/2014 Dense vegetation limits the inspector's visibility to identify signs of pipe failure (leaks) along the slope. Recommend removing vegetation along pipe alignment to conduct proper inspection of structure. (O. Magana - DWR UCIP)  
FIELD\_STRUCT\_DESC: 24-inch corrugated metal gravity drainage pipe through the levee, 9 feet below the crown. Flap gate on the waterside (WS) end. Brass cap No. 115 bench mark (BM) on the headwall on the landside (LS). [Additional Reference(s): DWR Levee Log, 2002 (HLM 9.47), listed as a 24-inch corrugated metal pipe (CMP). USACE San Joaquin O&M Manual, Unit 601 Part 1 (SJR 601.1), 1967, Revised 25 May 2011, (HLM 9.46), listed as a 24-inch CMP].

Levee crown looking downstream.

LS view: Toe from crown.

LS view: Slope and headwall at toe.

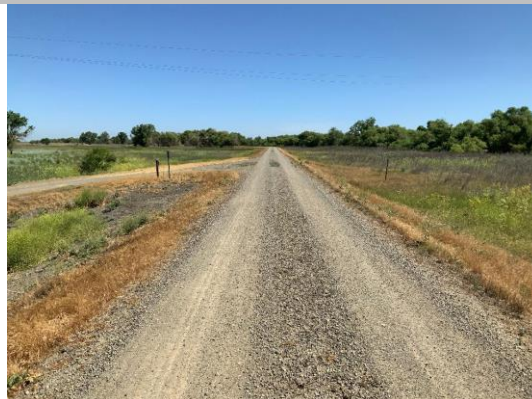
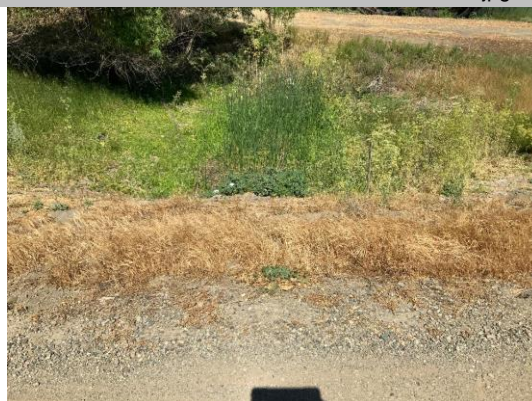
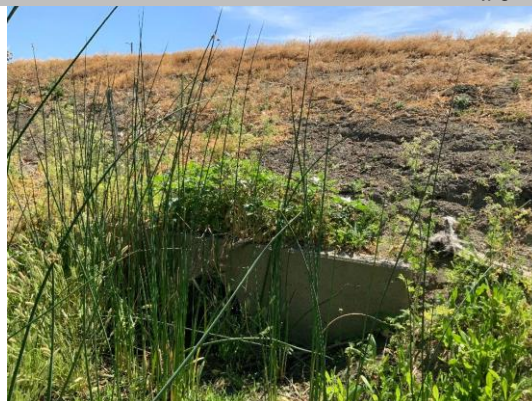
LM Start	<b>10.09</b>	Rating **	M	Issue No.	<b>34 (cont)</b>
LM End	<b>10.09</b>	Issue Type +	Ma	Location *	
Category	Supplemental		GPS Latitude/Longitude		
			Start	End	
Item	DWR UCIP LMA Responsibility		37.214229 °	37.214229 °	
			-120.784350 °	-120.784350 °	
DWR ID	19687

DS\_ID:19687  
FS\_ID:68231  
EP\_NO: N/A  
Repair Type: Non-Urgent  
EVAL Issue: Limited Inspection/No UCIP Evaluation  
Crossing Status: Found  
UCIP Comments: 06/7/2021 The record remains Non-Urgent. Some sediment buildup inside LS pipe inlet. LS pipe inlet also covered by some vegetation. Recommend cleaning out sediment and removing vegetation. WS flapgate partially underwater and covered by vegetation, limited inspection of both WS and LS. No permit was found authorizing this encroachment. CVFPB will need to review crossing to determine owner. The UCIP inspection was completed with GEI staff, P. Espinoza. (H. Dunn- GEI) 05/14/2014 Dense vegetation limits the inspector's visibility to identify signs of pipe failure (leaks) along the slope. Recommend removing vegetation along pipe alignment to conduct proper inspection of structure. (O. Magana - DWR UCIP)  
FIELD\_STRUCT\_DESC: 24-inch corrugated metal gravity drainage pipe through the levee, 11.7 feet below the crown. Flap gate on the waterside (WS) end. Brass cap No. 115 bench mark (BM) on the headwall on the landside (LS). [Additional Reference(s): DWR Levee Log, 2002 (HLM 10.13), listed as a 24-inch corrugated metal pipe (CMP). USACE San Joaquin O&M Manual, Unit 601 Part 1 (SJR 601.1), 1967, Revised 25 May 2011, (HLM 10.12), listed as a 24-inch CMP].

Levee crown looking downstream.

LS view: Toe from crown.

LS view: Slope and headwall from toe.

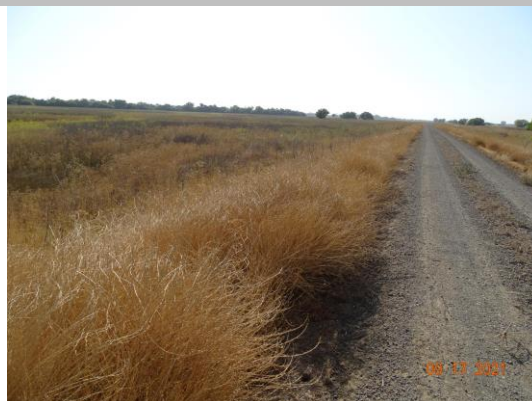
Photo 1 of 1 : FA\_2021\_NA0010\_120\_18\_20210929\_00043.jpg

LM Start	10.41	Rating **	M	Issue No.	18
LM End	10.55	Issue Type +	Ma	Location *	WS
Category	Earthen Levee			GPS Latitude/Longitude	
				Start	End
Item	Vegetation			37.210202 °	37.208645 °
				-120.781968 °	-120.780424 °
DWR ID	DWR_NA0010_02B_f_2021_18				
Comment Code					
V1 : Control annual grass and weeds on the levee slopes and easements.					
Inspector Comment

View of the waterside slope looking upstream. (Fall 2021)

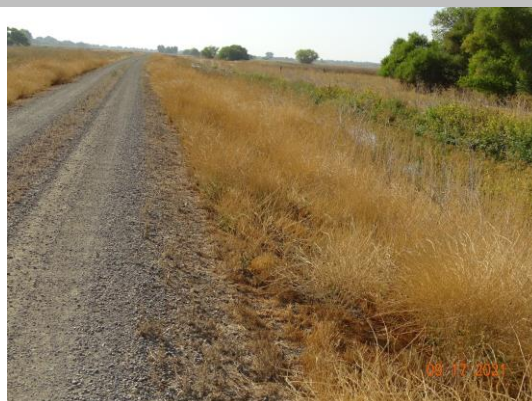
Photo 1 of 1 : FA\_2021\_NA0010\_120\_19\_20210929\_00044.jpg

LM Start	10.45	Rating **	M	Issue No.	19
LM End	10.70	Issue Type +	Ma	Location *	LS
Category	Earthen Levee			GPS Latitude/Longitude	
				Start	End
Item	Vegetation			37.209791 °	37.206954 °
				-120.781560 °	-120.778788 °
DWR ID	DWR_NA0010_02B_f_2021_19				
Comment Code					
V1 : Control annual grass and weeds on the levee slopes and easements.					
Inspector Comment

Looking upstream along the landside slope. (Fall 2021)

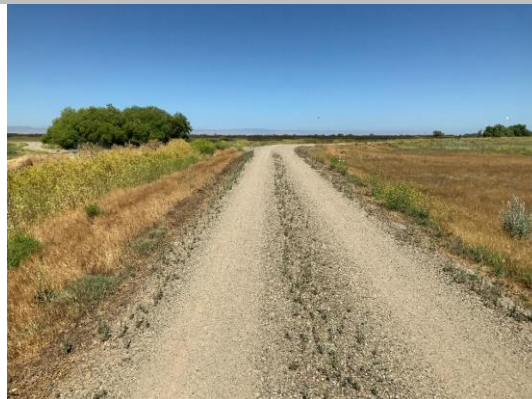
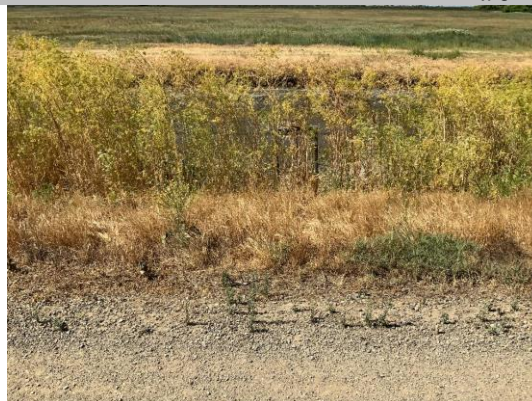
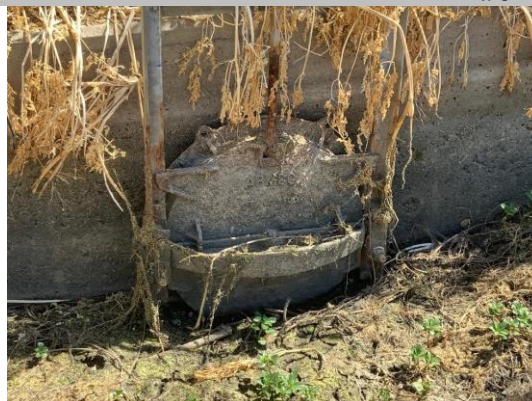
LM Start	10.78	Rating **	M	Issue No.	35 (cont)
LM End	10.78	Issue Type +	Ma	Location *	
Category	Supplemental			GPS Latitude/Longitude	
				Start	End
Item	DWR UCIP LMA Responsibility			37.206352 °	37.206352 °
				-120.777634 °	-120.777634 °
DWR ID	19688

DS\_ID:19688  
FS\_ID:67614  
EP\_NO: N/A  
Repair Type: Non-Urgent  
EVAL Issue: Limited Inspection/No UCIP Evaluation  
Crossing Status: Found  
UCIP Comments: 06/7/2021 The record remains Non-Urgent. WS end and flapgate is overgrown with dense vegetation limiting inspection, recommend removal. No permit was found authorizing this encroachment. CVFPB will need to review crossing to determine owner. The UCIP inspection was completed with GEI staff, P. Espinoza. (H. Dunn – GEI) 05/14/2014 Dense vegetation limits the inspector's visibility to identify signs of pipe failure (leaks) along the slope. Recommend removing vegetation along pipe alignment to conduct proper inspection of structure. Sediment buildup in pipe visible on landward side--recommend clearing. (O. Magana - DWR UCIP)  
FIELD\_STRUCT\_DESC: 24-inch corrugated metal gravity drainage pipe through the levee, 8 feet below the crown. Flap gate on the waterside (WS) end. Brass cap No. 115 bench mark (BM) on the headwall on the landside (LS). [Additional Reference(s): DWR Levee Log, 2002 (HLM 10.82), listed as a 24-inch corrugated metal pipe (CMP). USACE San Joaquin O&M Manual, Unit 601 Part 1 (SJR 601.1), 1967, Revised 25 May 2011, (HLM 10.81), listed as a 24-inch CMP].

Levee crown looking downstream.

LS view: Toe from crown.

LS view: Closeup of pipe inlet and slidegate at toe.

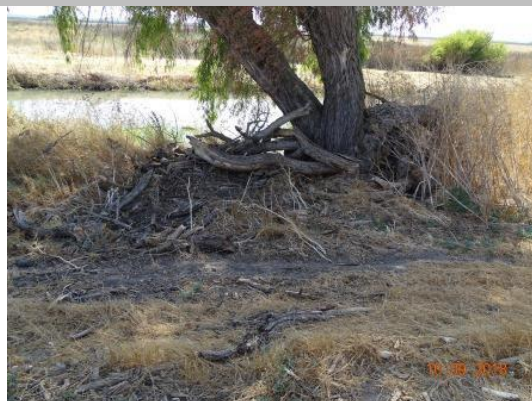
Photo 1 of 1 : FA\_2021\_NA0010\_120\_14\_20210830\_00002.jpg

LM Start	10.94	Rating **	M	Issue No.	14
LM End	10.94	Issue Type +	Ma	Location *	LS
Category	Earthen Levee			GPS Latitude/Longitude	
				Start	End
Item	Encroachments			37.205711 °	37.205711 °
				-120.774741 °	-120.774741 °
DWR ID	DWR_NA0010_02B_f_2015_14				
Comment Code					
PR : Prunings					
Inspector Comment					
Remove prunings from landside toe.

Prunings at landside toe. (Fall 2018)

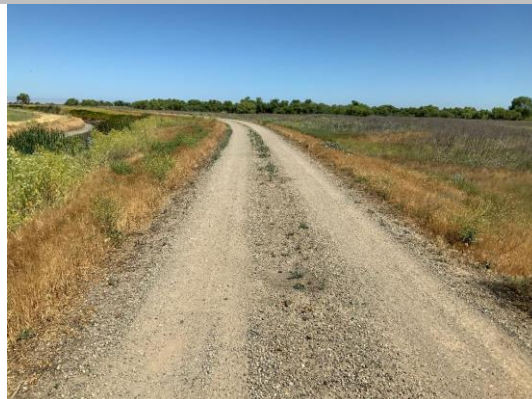
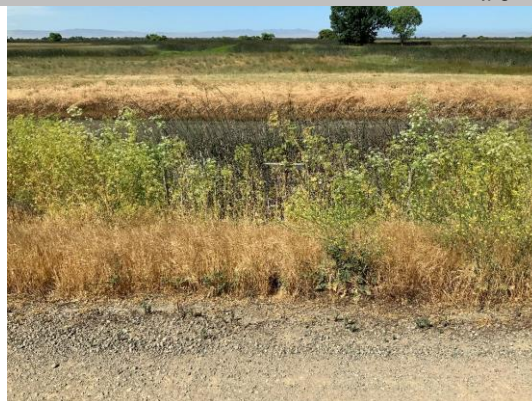
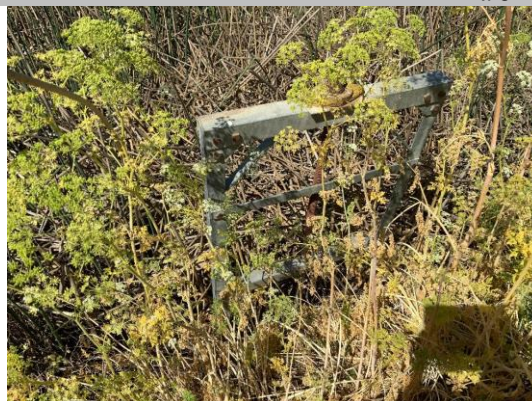
LM Start	<b>11.14</b>	Rating **	M	Issue No.	<b>36 (cont)</b>
LM End	<b>11.14</b>	Issue Type +	Ma	Location *	
Category	Supplemental		GPS Latitude/Longitude		
			Start	End	
Item	DWR UCIP LMA Responsibility		37.204640 °	37.204640 °	
			-120.771564 °	-120.771564 °	
DWR ID	19689

DS\_ID:19689  
FS\_ID:67615  
EP\_NO: N/A  
Repair Type: Non-Urgent  
EVAL Issue: Limited Inspection/No UCIP Evaluation  
Crossing Status: Found  
UCIP Comments: 06/7/2021 The record remains Non-Urgent. Dense vegetation covering LS pipe inlet limiting inspection, recommend removal. No permit was found authorizing this encroachment. CVFPB will need to review crossing to determine owner. The UCIP inspection was completed with GEI staff, P. Espinoza. (H. Dunn- GEI) 05/14/201 Dense vegetation limits the inspector's visibility to identify signs of pipe failure (leaks) along the slope. Recommend removing vegetation along pipe alignment to conduct proper inspection of structure. (O. Magana - DWR UCIP)  
FIELD\_STRUCT\_DESC: 24-inch corrugated metal gravity drainage pipe through the levee, 8 feet below the crown. Flap gate on the waterside (WS) end. Brass cap No. 115 bench mark (BM) on the headwall on the landside (LS). [Additional Reference(s): DWR Levee Log, 2002 (HLM 11.18), listed as a 24-inch corrugated metal pipe (CMP). USACE San Joaquin O&M Manual, Unit 601 Part 1 (SJR 601.1), 1967, Revised 25 May 2011, (HLM 11.17), listed as a 24-inch CMP].

Levee crown looking downstream.

LS view: Toe from crown.

LS view: Headwall barely visible at toe, inlet covered in vegetation.

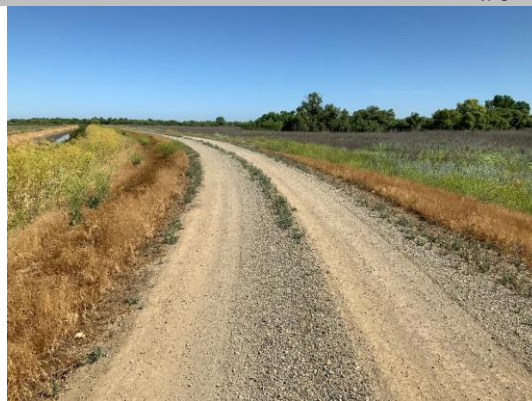
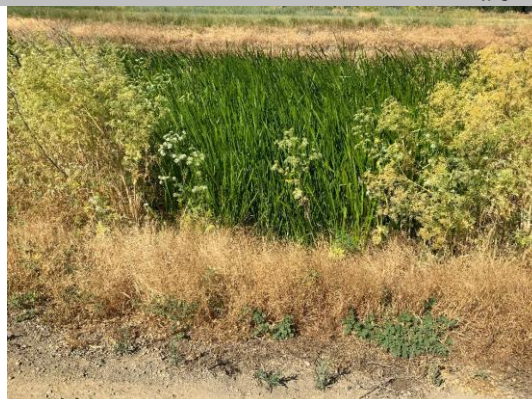
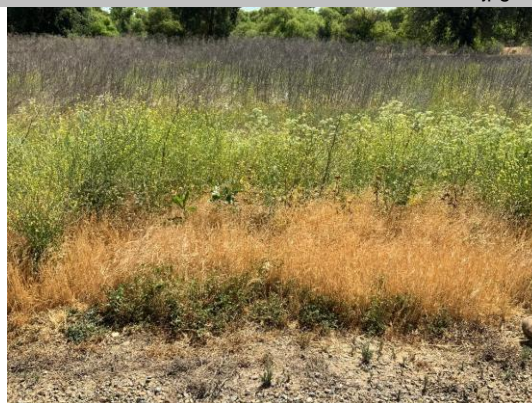
LM Start	<b>11.40</b>	Rating **	M	Issue No.	<b>37 (cont)</b>
LM End	<b>11.40</b>	Issue Type +	Ma	Location *	
Category	Supplemental		GPS Latitude/Longitude		
			Start	End	
Item	DWR UCIP LMA Responsibility		37.201792 °	37.201792 °	
			-120.768462 °	-120.768462 °	
DWR ID	19690

DS\_ID:19690  
FS\_ID:68232  
EP\_NO: N/A  
Repair Type: Non-Urgent  
EVAL Issue: Limited Inspection/No UCIP Evaluation  
Crossing Status: Found  
UCIP Comments: 06/7/2021 The record remains Non-Urgent. Dense vegetation over LS end, cannot see pipe inlet, recommend vegetation removal. WS flapgate has some vegetation covering it, recommend clearing. No permit was found authorizing this encroachment. CVFPB will need to review crossing to determine owner. The UCIP inspection was completed with GEI staff, P. Espinoza. (H. Dunn – GEI)

Levee crown looking downstream.

LS view: Toe from crown, dense vegetation, no pipe visible.

WS view: Toe from crown.

05/14/2014 Dense vegetation limits the inspector's visibility to identify signs of pipe failure (leaks) along the slope. Recommend removing vegetation along pipe alignment to conduct proper inspection of structure. (O. Magana - DWR UCIP)  
FIELD\_STRUCT\_DESC: 24-inch corrugated metal gravity drainage pipe through the levee, 8 feet below the crown. Flap gate on the waterside (WS) end. Screw gate on the landside (LS). [Additional Reference(s): DWR Levee Log, 2002 (HLM 11.45), listed as a 24-inch corrugated metal pipe (CMP). USACE San Joaquin O&M Manual, Unit 601 Part 1 (SJR 601.1), 1967, Revised 25 May 2011, (HLM 11.43), listed as a 24-inch CMP].  
FS Date: 6/7/2021

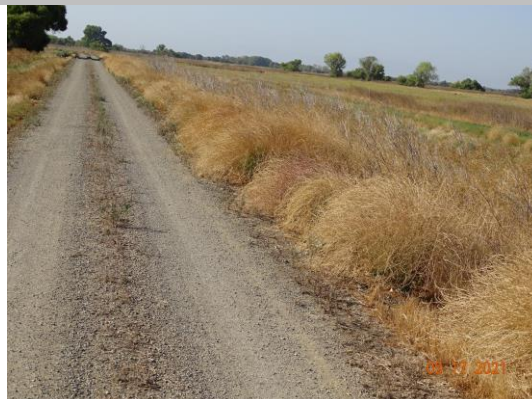
Photo 1 of 1 : FA\_2021\_NA0010\_120\_17\_20210929\_00045.jpg

LM Start	11.43	Rating **	U	Issue No.	17
LM End	11.57	Issue Type +	Ma	Location *	LS
Category	Earthen Levee			GPS Latitude/Longitude	
				Start	End
Item	Vegetation			37.201284 °	37.199268 °
				-120.768467 °	-120.768818 °
DWR ID	DWR_NA0010_02B_f_2021_17				
Comment Code					
V1 : Control annual grass and weeds on the levee slopes and easements.					
Inspector Comment

View of the vegetation on the landside shoulder and slope. (Fall 2021)

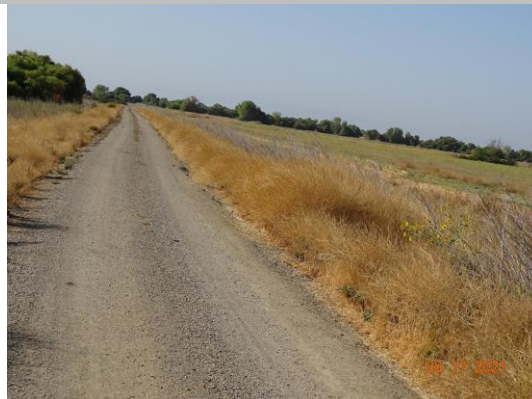
Photo 1 of 1 : FA\_2021\_NA0010\_120\_21\_20210929\_00046.jpg

LM Start	12.06	Rating **	U	Issue No.	21
LM End	13.15	Issue Type +	Ma	Location *	LS
Category	Earthen Levee			GPS Latitude/Longitude	
				Start	End
Item	Vegetation			37.193628 °	37.179596 °
				-120.763859 °	-120.765134 °
DWR ID	DWR_NA0010_02B_f_2021_21				
Comment Code					
V1 : Control annual grass and weeds on the levee slopes and easements.					
Inspector Comment

View of dense vegetation growing on the landside slope. (Fall 2021)

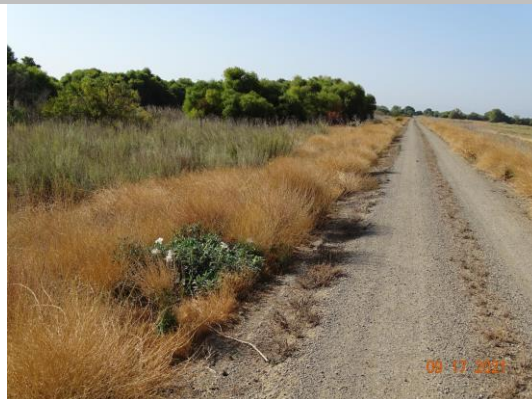
Photo 1 of 1 : FA\_2021\_NA0010\_120\_23\_20210929\_00047.jpg

LM Start	12.12	Rating **	M	Issue No.	23
LM End	12.17	Issue Type +	Ma	Location *	WS
Category	Earthen Levee			GPS Latitude/Longitude	
				Start	End
Item	Vegetation			37.192728 °	37.192093 °
				-120.764139 °	-120.764350 °
DWR ID	DWR_NA0010_02B_f_2021_23				
Comment Code					
V1 : Control annual grass and weeds on the levee slopes and easements.					
Inspector Comment

View of the waterside slope looking upstream. (Fall 2021)

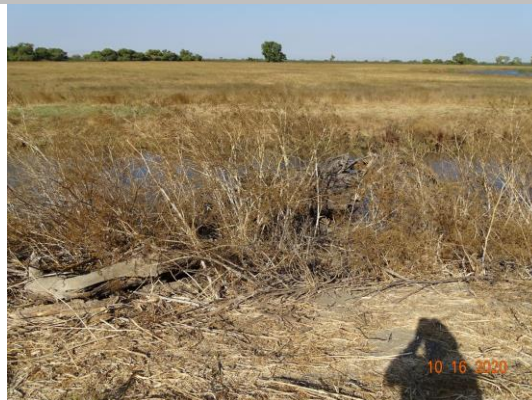
Photo 1 of 1 : FA\_2021\_NA0010\_120\_1\_20210830\_00001.jpg

LM Start	12.21	Rating **	M	Issue No.	1
LM End	12.21	Issue Type +	Ma	Location *	LS
Category	Earthen Levee			GPS Latitude/Longitude	
				Start	End
Item	Encroachments			37.191528 °	37.191528 °
				-120.764541 °	-120.764541 °
DWR ID	DWR_NA0010_02B_f_2014_1				
Comment Code					
TR : Tree or limb					
Inspector Comment					
Fallen tree limbs are located on the landside slope.

Fallen tree on the landside slope. (Fall 2020)

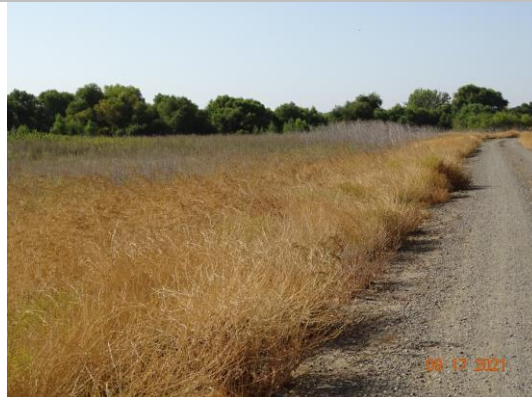
Photo 1 of 1 : FA\_2021\_NA0010\_120\_24\_20210929\_00048.jpg

LM Start	12.46	Rating **	U	Issue No.	24
LM End	13.25	Issue Type +	Ma	Location *	WS
Category	Earthen Levee			GPS Latitude/Longitude	
				Start	End
Item	Vegetation			37.188091 °	37.178378 °
				-120.766158 °	-120.764310 °
DWR ID	DWR_NA0010_02B_f_2021_24				
Comment Code					
V1 : Control annual grass and weeds on the levee slopes and easements.					
Inspector Comment

View of vegetation on the waterside slope looking upstream. (Fall 2021)

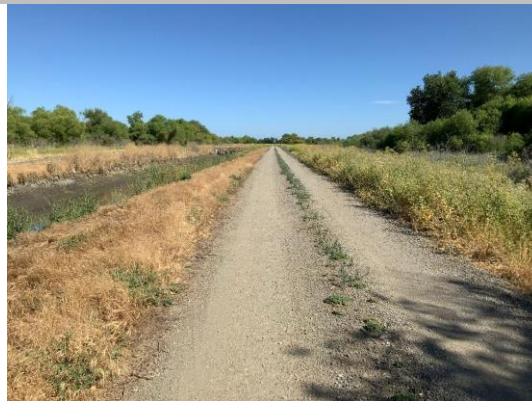
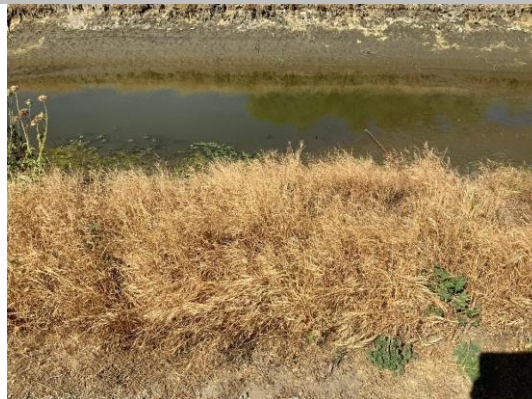
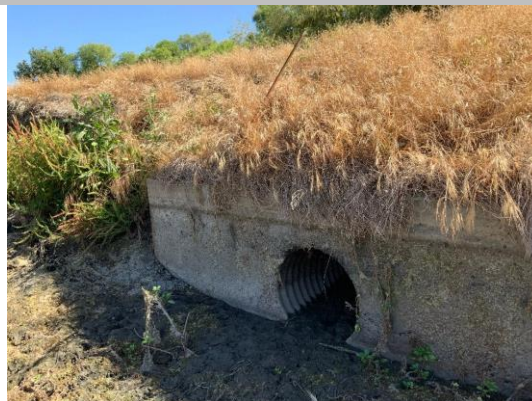
LM Start	13.18	Rating **	M	Issue No.	38	
LM End	13.18	Issue Type +	Ma	Location *		
Category	Supplemental			GPS Latitude/Longitude		
				Start	End	
Item	DWR UCIP LMA Responsibility			37.179265 °	37.179265 °	
				-120.764870 °	-120.764870 °	
DWR ID	19663

Comment Code						
Inspector Comment						
DS_ID:19663 FS_ID:67725 EP_NO: N/A Repair Type: Non-Urgent EVAL Issue: Limited Inspection/No UCIP Evaluation Crossing Status: Found UCIP Comments: 06/7/2021 The record remains Non-Urgent. Sediment buildup inside LS pipe inlet, recommend cleaning out. Dense vegetation over WS end limited inspection, recommend removal. No permit was found authorizing this encroachment. CVFPB will need to review crossing to determine owner. The UCIP inspection was completed with GEI staff, P. Espinoza. (H. Dunn - GEI) 05/14/201 Dense vegetation limits the inspector's visibility to identify signs of pipe failure (leaks) along the slope. Recommend removing vegetation along pipe alignment to conduct proper inspection of structure. Sediment buildup in pipe-- recommend clearing. (O. Magana - DWR UCIP) FIELD_STRUCT_DESC: 24-inch corrugated metal gravity drainage pipe through the levee, 6.5 feet below the crown. Slide gate in a pipe riser on the waterside (WS) slope. [Additional Reference(s): DWR Levee Log, 2002 (HLM 13.23), listed as a 24-inch corrugated metal pipe (CMP). USACE San Joaquin O&M Manual, Unit 601 Part 1 (SJR 601.1), 1967, Revised 25 May 2011, (recorded as HLM 13.32 should be HLM 13.22), listed as a 24-inch CMP]. FS Date: 6/7/2021

Levee crown looking downstream.

LS view: Toe from crown.

LS view: Slope, headwall, and pipe inlet at toe.

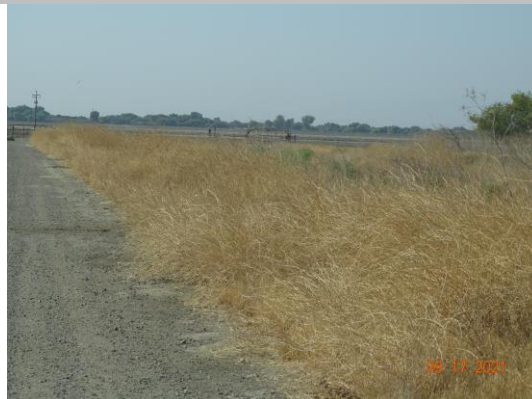
Photo 1 of 1 : FA\_2021\_NA0010\_120\_27\_20210929\_00049.jpg

LM Start	13.64	Rating **	U	Issue No.	27
LM End	13.74	Issue Type +	Ma	Location *	LS
Category	Earthen Levee			GPS Latitude/Longitude	
				Start	End
Item	Vegetation			37.173743 °	37.172298 °
				-120.761047 °	-120.761210 °
DWR ID	DWR_NA0010_02B_f_2021_27				
Comment Code					
V1 : Control annual grass and weeds on the levee slopes and easements.					
Inspector Comment

View of grassy vegetation on the landside slope. (Fall 2021)

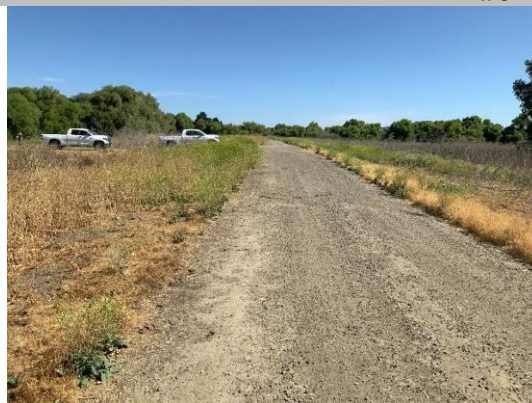
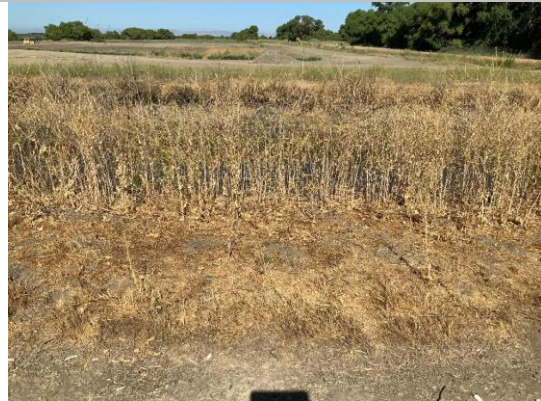
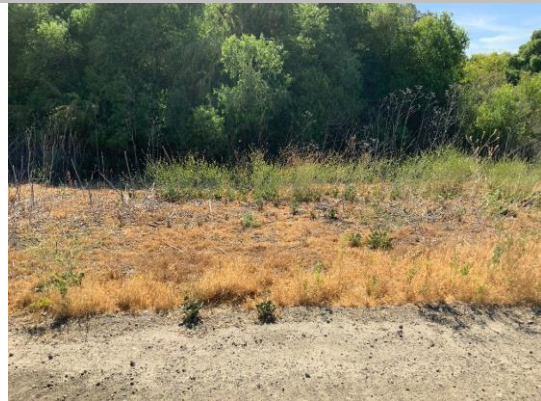
LM Start	13.67	Rating **	M	Issue No.	39	
LM End	13.67	Issue Type +	En	Location *		
Category	Supplemental			GPS Latitude/Longitude		
				Start	End	
Item	DWR UCIP Field Study			37.173327 °	37.173327 °	
				-120.761055 °	-120.761055 °	
DWR ID	19664

Comment Code						
Inspector Comment						
DS_ID:19664 FS_ID:67618 EP_NO: 14138 Repair Type: Non-Urgent EVAL Issue: Limited Inspection/No UCIP Evaluation Crossing Status: Not Found UCIP Comments: 06/7/2021 The record remains Non-Urgent. Pipe not found by visual inspection. Dense vegetation on either side, no pipe visible. Recommend removing vegetation to assess if pipe is there. The UCIP inspection was completed with GEI staff, P. Espinoza. (H. Dunn - GEI)05/14/201 Dense vegetation limits the inspector's visibility to identify signs of pipe failure (leaks) along the slope. Recommend removing vegetation along pipe alignment to conduct proper inspection of structure. (O. Magana - DWR UCIP) FIELD_STRUCT_DESC: 24-inch corrugated metal gravity drainage pipe through the levee, 10 feet below the crown. Concrete cutoff wall at the centerline of the pipe. Flap gate on the landside (LS) end. Screw gate on the waterside (WS) end with accessible walkway. (Plans to install a 24-inch reinforced concrete pipe through the levee authorized under Permit No. 14138, 1985 - United States Fish and Wildlife Service). [Additional Reference(s): DWR Levee Log, 2002 (HLM 13.71), listed as a 24-inch corrugated metal pipe]. FS Date: 6/7/2021

Levee crown looking downstream.

LS view: Toe from crown, pipe not visible.

WS view: Toe from crown, pipe not visible.

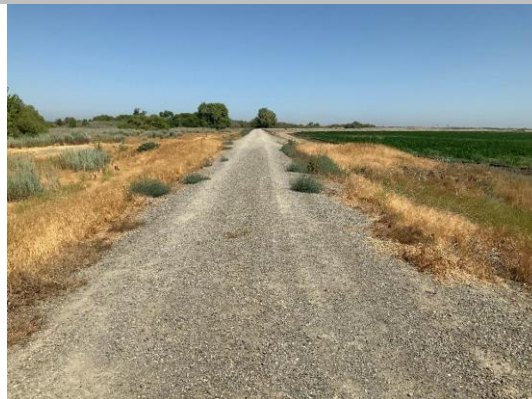
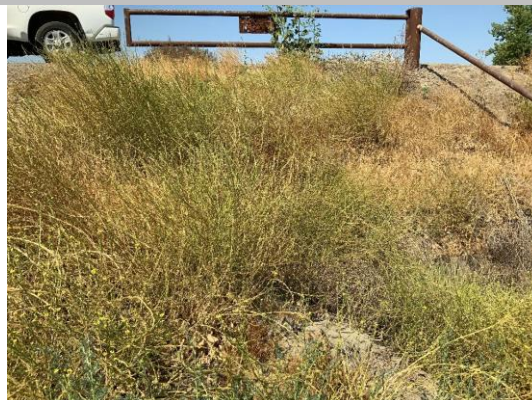
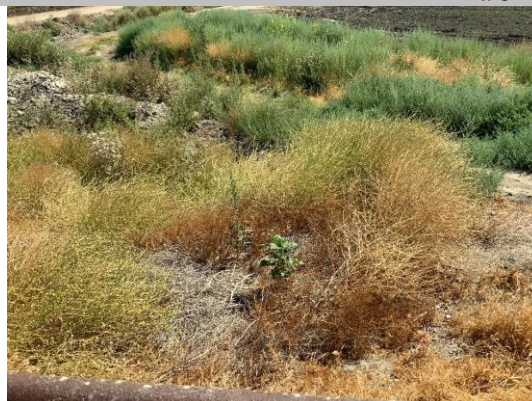
DS\_ID:19691  
FS\_ID:67937  
EP\_NO: N/A  
Repair Type: Non-Urgent  
EVAL Issue: Limited Inspection/No UCIP Evaluation  
Crossing Status: Found  
UCIP Comments: 07/12/2021 The record remains Non-Urgent. Dense vegetation over LS pipe inlet, headwall just barely visible, recommend removal. No permit was found authorizing this encroachment. CVFPB will need to review crossing to determine owner. The UCIP inspection was completed with GEI staff, P. Espinoza. (H. Dunn – GEI)

Levee crown looking upstream.

LS view: Slope from toe.

LS view: Toe from crown.

04/17/2014 Need to contact owner. Recommend removing tall grass on landward slope and clearing sediment build up inside pipe. (O. Magana - DWR UCIP)

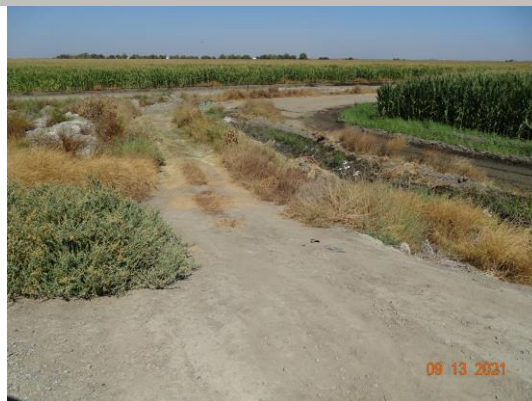
Photo 1 of 1 : FA\_2021\_NA0010\_121\_6\_20210929\_00020.jpg

LM Start	0.43	Rating **	M	Issue No.	6
LM End	0.43	Issue Type +	En	Location *	LS
Category	Earthen Levee			GPS Latitude/Longitude	
				Start	End
Item	Encroachments			37.106121 °	37.106121 °
				-120.585680 °	-120.585680 °
DWR ID	DWR_NA0010_03_f_2017_6				
Comment Code					
RA : Ramp					
Inspector Comment

Looking east at the landside slope. (Fall 2021)

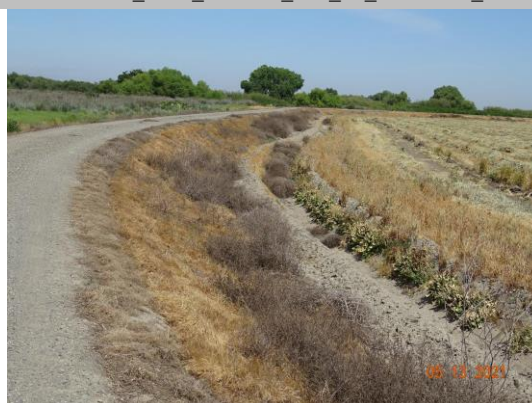
Photo 1 of 1 : FA\_2021\_NA0010\_121\_13\_20210830\_00005.jpg

LM Start	0.43	Rating **	M	Issue No.	13
LM End	2.02	Issue Type +	En	Location *	LS
Category	Earthen Levee			GPS Latitude/Longitude	
				Start	End
Item	Encroachments			37.106072 °	37.089499 °
				-120.585636 °	-120.568041 °
DWR ID	DWR_NA0010_03_s_2021_13				
Comment Code					
DT : Ditch					
Inspector Comment					
Landowner has dug a ditch in the landside toe.

View of ditch dug on the landside toe. (Spring 2021)

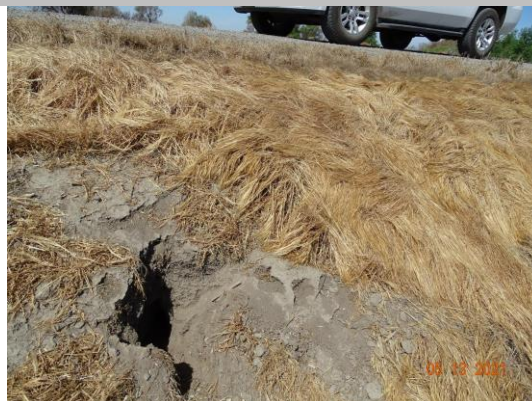
Photo 1 of 1 : FA\_2021\_NA0010\_121\_10\_20210830\_00004.jpg

LM Start	0.57	Rating **	U	Issue No.	10
LM End	0.57	Issue Type +	Ma	Location *	LS
Category	Earthen Levee			GPS Latitude/Longitude	
				Start	End
Item	Animal Control			37.104343 °	37.104343 °
				-120.584348 °	-120.584348 °
DWR ID	DWR_NA0010_03_s_2021_10				
Comment Code					
A3 : No rodents visible, but rodent burrows visible; need to backfill and compact or grout burrows.					
Inspector Comment

Several large rodent burrows observed at this location. (Spring 2021)

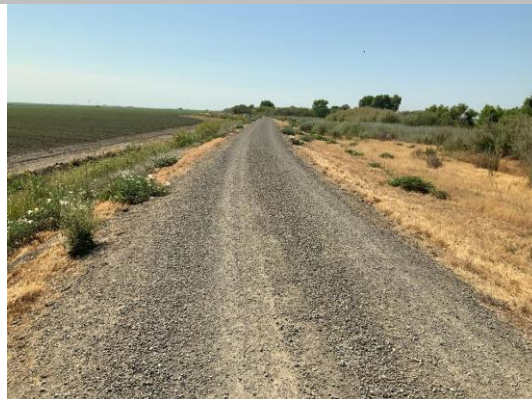
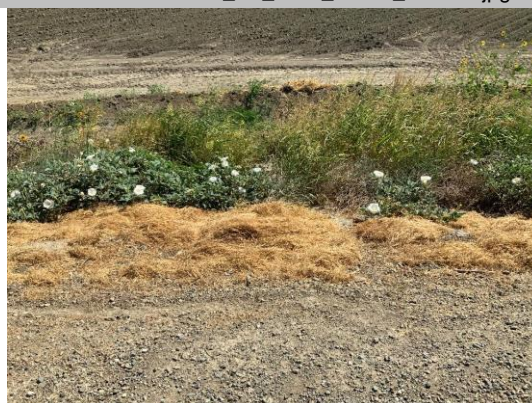
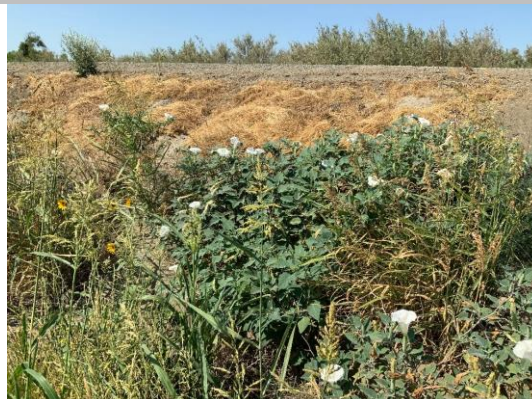
DS\_ID:19692  
FS\_ID:67938  
EP\_NO: N/A  
Repair Type: Non-Urgent  
EVAL Issue: Limited Inspection/No UCIP Evaluation  
Crossing Status: Found  
UCIP Comments: 07/12/2021 The record has been upgraded from No Action Needed to Non-Urgent. Dense vegetation over LS pipe inlet, headwall barely visible. Minor vegetation on WS, recommend removal on both ends. No permit was found authorizing this encroachment. CVFPB will need to review crossing to determine owner. The UCIP inspection was completed with GEI staff, P. Espinoza. (H. Dunn – GEI)  
FIELD\_STRUCT\_DESC: 24-inch corrugated metal gravity drainage pipe through the levee, 9.3 feet below the crown. Flap gate on the waterside (WS) end. [Additional Reference(s): DWR Levee Log, 2002 (HLM 0.78), listed as a 24-inch corrugated metal pipe (CMP). USACE San Joaquin O&M Manual, Unit 601 Part 1 (SJR 601.1), 1967, Revised 25 May 2011, (HLM 0.77), listed as a 24-inch CMP].

Levee crown.

LS view: Toe from crown.

LS view: Slope from toe.

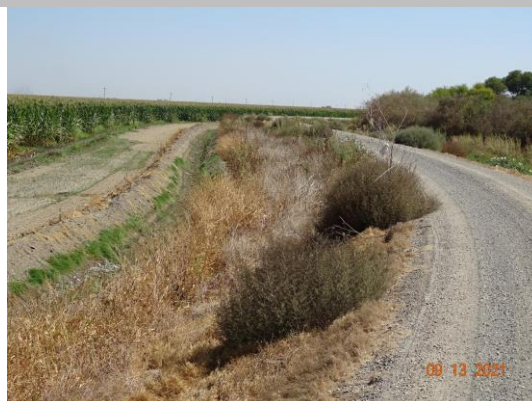
Photo 1 of 1 : FA\_2021\_NA0010\_121\_7\_20210929\_00021.jpg

LM Start	1.00	Rating **	M	Issue No.	7
LM End	1.29	Issue Type +	Ma	Location *	LS
Category	Earthen Levee			GPS Latitude/Longitude	
				Start	End
Item	Vegetation			37.100354 °	37.096845 °
				-120.578810 °	-120.576335 °
DWR ID	DWR_NA0010_03_f _ 2021_7				
Comment Code					
V1 : Control annual grass and weeds on the levee slopes and easements.					
Inspector Comment

Looking upstream along the landside slope. (Fall 2021)

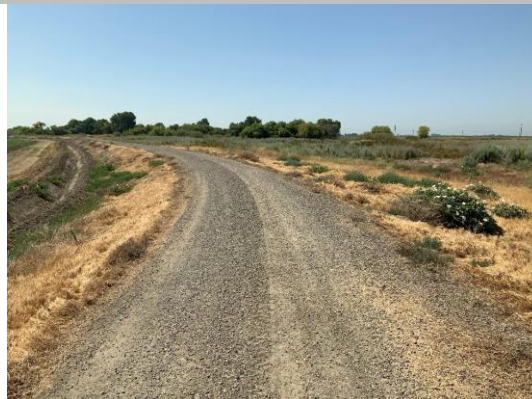
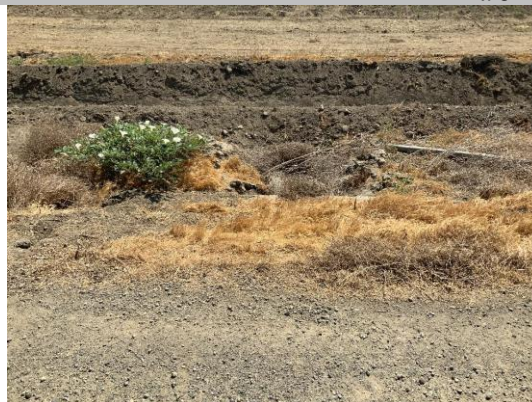
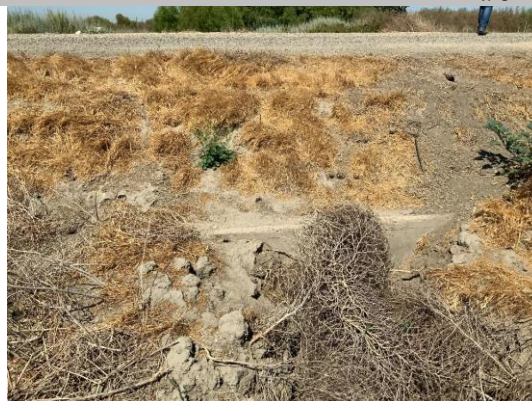
Comment Code						
Inspector Comment						
DS_ID:19693 FS_ID:67939 EP_NO: N/A Repair Type: Non-Urgent EVAL Issue: Limited Inspection/No UCIP Evaluation Crossing Status: Found UCIP Comments: 07/12/2021 The record remains Non-Urgent. There is dense vegetation over LS pipe inlet and WS flapgate, recommend removal. No permit was found authorizing this encroachment. CVFPB will need to review crossing to determine owner. The UCIP inspection was completed with GEI staff, P. Espinoza. (H. Dunn – GEI)  04/17/2014 Sediment buildup in pipe visible from landward side-- recommend clearing. (O. Magana - DWR UCIP) FIELD_STRUCT_DESC: 24-inch corrugated metal gravity drainage pipe through the levee, 6.8 feet below the crown. Flap gate on the waterside (WS) end. [Additional Reference(s): DWR Levee Log, 2002 (HLM 1.73), listed as a 24-inch corrugated metal pipe (CMP). USACE San Joaquin O&M Manual, Unit 601 Part 1 (SJR 601.1), 1967, Revised 25 May 2011, (HLM 1.72), listed as a 24-inch CMP]. FS Date: 7/12/2021

Levee crown.

LS view: Toe from crown.

LS view: Slope and headwall from toe.

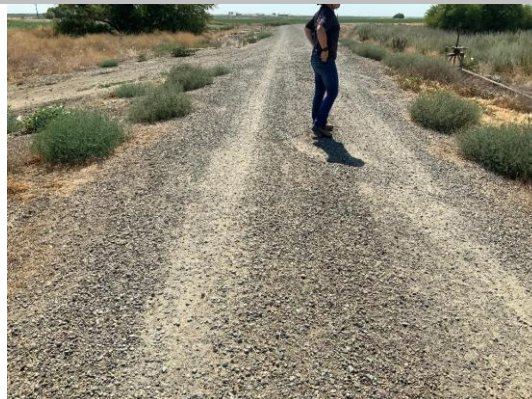
Photo 1 of 3 : UCIP\_FA\_2021\_67940\_101366.jpg

DS\_ID:19694  
FS\_ID:67940  
EP\_NO: N/A  
Repair Type: Non-Urgent  
EVAL Issue: Limited Inspection/No UCIP Evaluation  
Crossing Status: Found  
UCIP Comments: 07/12/2021 The record remains Non-Urgent. Dense vegetation over WS and LS inlet/outlet, recommend removal. As mentioned in the previous inspection, there is a 16 inch metal pipe directly opposite the WS pipe slidegate/outlet that goes just underground and out through to the channel. Recommend contacting owner for more information on these WS appurtenances. No permit was found authorizing this encroachment. CVFPB will need to review crossing to determine owner. The UCIP inspection was completed with GEI staff, P. Espinoza. (H. Dunn ? GEI) 04/17/2014 Need to contact owner--additional appurtenances found on waterward side not part of original description. Unable to determine if walkway, pump, and pipe through waterward berm is if part of original crossing. (O. Magana - DWR UCIP)

Levee crown.

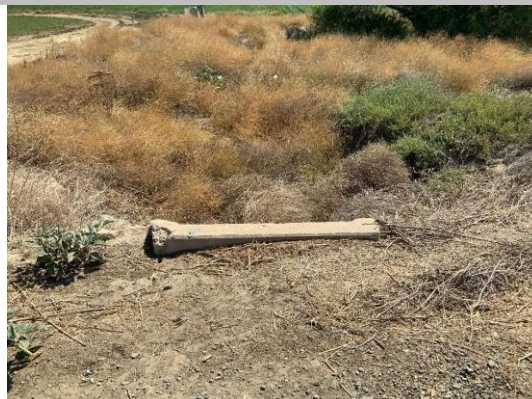
Photo 2 of 3 : UCIP\_FA\_2021\_67940\_101363.jpg

LS view: Headwall visible at toe from crown.

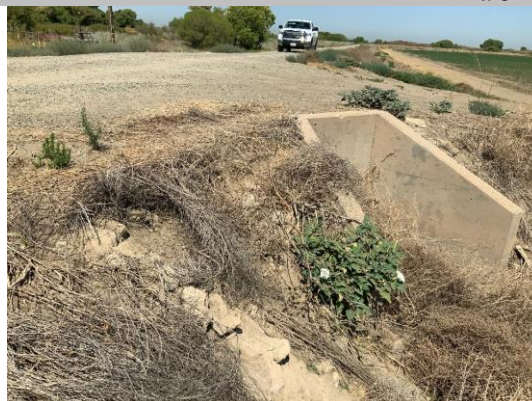
Photo 3 of 3 : UCIP\_FA\_2021\_67940\_101365.jpg

LS view: Slope from toe.

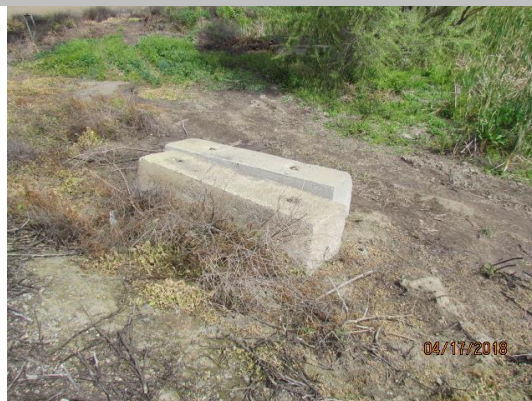
Photo 1 of 1 : FA\_2021\_NA0010\_121\_5\_20210830\_00001.jpg

LM Start	2.05	Rating **	U	Issue No.	5
LM End	2.05	Issue Type +	En	Location *	LS
Category	Earthen Levee			GPS Latitude/Longitude	
				Start	End
Item	Encroachments			37.089289 °	37.089289 °
				-120.567463 °	-120.567463 °
DWR ID	DWR_NA0010_03_s_2018_5				
Comment Code					
MA : Material					
Inspector Comment					
Two large concrete blocks are located on the landward toe.

Looking southwest at concrete blocks on landward toe. (Spring 2018)

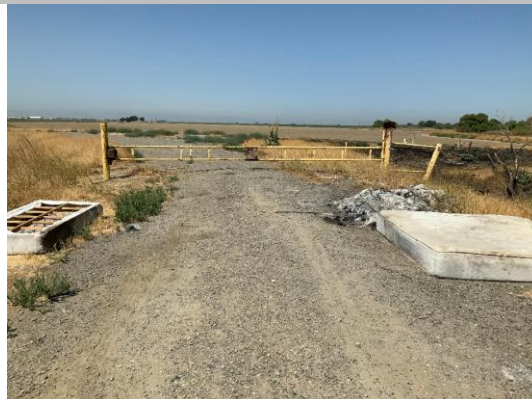
Photo 1 of 3 : UCIP\_FA\_2021\_68823\_101380.jpg

Comment Code						
Inspector Comment						
DS_ID:19977 FS_ID:68823 EP_NO: 5024 Repair Type: Non-Urgent EVAL Issue: Limited Inspection/No UCIP Evaluation Crossing Status: Found UCIP Comments: 07/12/2021 The record remains Non-Urgent. WS pipe outlet is underwater, limited inspection. LS headwall and pipe inlets have human trash around and safety concerns to inspectors due to homeless encampments. Limited inspection on both WS due to water and LS due to safety concerns to the inspectors. The UCIP inspection was completed with GEI staff, P. Espinoza. (H. Dunn – GEI)  10/27/2017 This structure is inspected annually under the Structure and Channel Summer Inspection (part of the Levee Inspection Program) conducted by the DWR Flood Project Integrity and Inspection Branch (FPIIB). (O. Magana - DWR UCIP) 04/17/2014 Slide gates blocked by sediment. Recommend contacting owner to determine status of crossing. Crossing appears to be abandoned. (O. Magana - DWR UCIP) FIELD_STRUCT_DESC: [San Joaquin River Diversion Structure] 1 of 4: 72-inch by 60-inch reinforced concrete box gravity drainage culvert through the levee, 21 feet below the crown. Slide gate on the waterside (WS). Concrete headwall on each end. Landside (LS) slope cobble revetted. Flashboards on the downstream side of the structure. [Additional Resource(s): DWR Levee Log, 2002 (HLM 0.03), listed as four 6-foot by 5-foot concrete culverts] FS Date: 7/12/2021

Levee crown.
