## Flood Control Project Maintenance Levee Inspections

### Fall 2021 Levee Maintenance Deficiency Summary Report

#### San Joaquin River Basin

NA0010 Lower San Joaquin Levee District	Overall LMA Rating	Total LMA Miles							
	U	191.27							
Rated Item	Maintenance Deficiency				Enforcement		Design & System Obsolescence		
	M Miles	U Miles	M + 4U Miles	Threshold %	M Miles	U Miles	M Miles	U Miles	
<i>Earthen Levee</i>									
Vegetation	47.00	9.57	85.28	44.59%					
Trim / Thin Trees	0.10		0.10	0.05%					
Encroachments	0.23	0.02	0.31	0.16%	9.29	0.59			
Animal Control	7.67	2.19	16.43	8.59%					
Slope Stability	0.05	0.01	0.09	0.05%					
Erosion / Bank Caving	0.13	0.81	3.37	1.76%					
Crown Surface / Depressions / Rutting	0.01		0.01	0.01%					
Repair Gates	0.02	0.02	0.10	0.05%					
<i>Rivers, Channels &amp; Designated Floodways</i>									
Encroachments					0.01	0.01			
<i>Supplemental</i>									
DWR Erosion Survey	0.12	0.17	0.80	0.42%					
DWR UCIP Field Study					1.29	0.05			
DWR UCIP LMA Responsibility									
<i>LMA Totals:</i>	55.33	12.79	106.49	55.67%	10.59	0.65	0.00	0.00

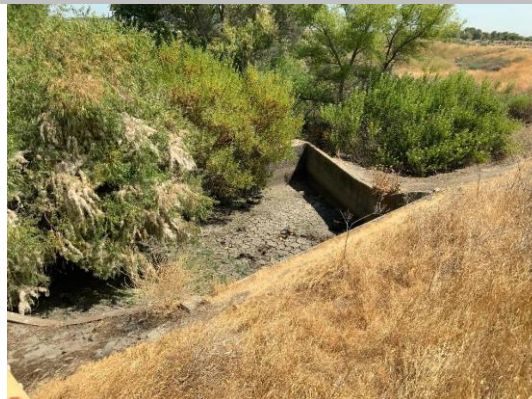
Photo 2 of 3 : UCIP\_FA\_2021\_68823\_101378.jpg

Comment Code						
Inspector Comment						
DS_ID:19977 FS_ID:68823 EP_NO: 5024 Repair Type: Non-Urgent EVAL Issue: Limited Inspection/No UCIP Evaluation Crossing Status: Found UCIP Comments: 07/12/2021 The record remains Non-Urgent. WS pipe outlet is underwater, limited inspection. LS headwall and pipe inlets have human trash around and safety concerns to inspectors due to homeless encampments. Limited inspection on both WS due to water and LS due to safety concerns to the inspectors. The UCIP inspection was completed with GEI staff, P. Espinoza. (H. Dunn – GEI)  10/27/2017 This structure is inspected annually under the Structure and Channel Summer Inspection (part of the Levee Inspection Program) conducted by the DWR Flood Project Integrity and Inspection Branch (FPIIB). (O. Magana - DWR UCIP) 04/17/2014 Slide gates blocked by sediment. Recommend contacting owner to determine status of crossing. Crossing appears to be abandoned. (O. Magana - DWR UCIP) FIELD_STRUCT_DESC: [San Joaquin River Diversion Structure] 1 of 4: 72-inch by 60-inch reinforced concrete box gravity drainage culvert through the levee, 21 feet below the crown. Slide gate on the waterside (WS). Concrete headwall on each end. Landside (LS) slope cobble revetted. Flashboards on the downstream side of the structure. [Additional Resource(s): DWR Levee Log, 2002 (HLM 0.03), listed as four 6-foot by 5-foot concrete culverts] FS Date: 7/12/2021

LS view: Toe from crown.

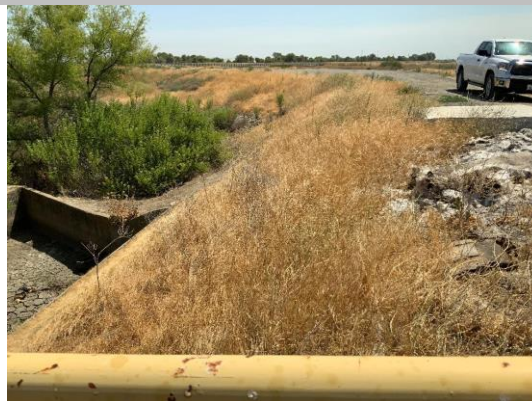
Photo 3 of 3 : UCIP\_FA\_2021\_68823\_101379.jpg

LS view: Slope from crown.

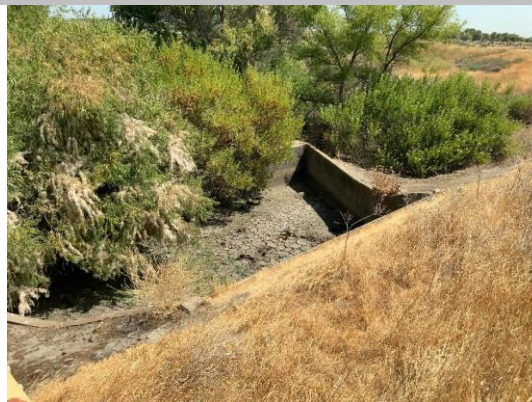
Photo 2 of 3 : UCIP\_FA\_2021\_68826\_101389.jpg

DS\_ID:24857  
FS\_ID:68826  
EP\_NO: 5024  
Repair Type: Non-Urgent  
EVAL Issue: Limited Inspection/No UCIP Evaluation  
Crossing Status: Found  
UCIP Comments: 07/12/2021 The record remains Non-Urgent. WS pipe outlet is underwater, limited inspection. LS headwall and pipe inlets have human trash around and safety concerns to inspectors due to homeless encampments. Limited inspection on both WS due to water and LS due to safety concerns to the inspectors. The UCIP inspection was completed with GEI staff, P. Espinoza. (H. Dunn – GEI)10/27/2017 This structure is inspected annually under the Structure and Channel Summer Inspection (part of the Levee Inspection Program) conducted by the DWR Flood Project Integrity and Inspection Branch (FPIIB). (O. Magana - DWR UCIP)  
04/17/2014 Slide gates blocked by sediment. Recommend contacting owner to determine status of crossing. Crossing appears to be abandoned. (O. Magana - DWR UCIP)

LS view: Toe from crown.

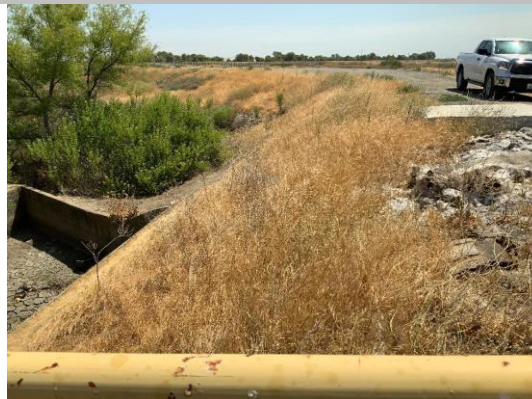
Photo 3 of 3 : UCIP\_FA\_2021\_68826\_101390.jpg

LS view: Slope from crown.

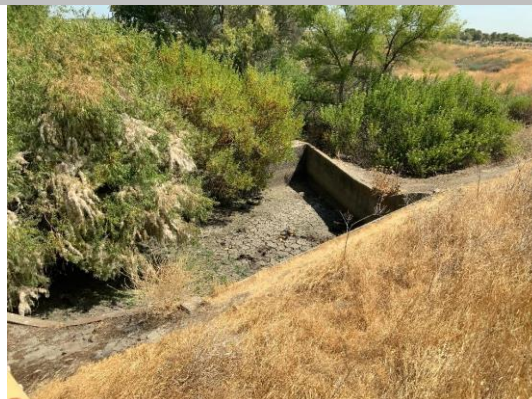
Photo 2 of 3 : UCIP\_FA\_2021\_68827\_101395.jpg

DS\_ID:24858  
FS\_ID:68827  
EP\_NO: 5024  
Repair Type: Non-Urgent  
EVAL Issue: Limited Inspection/No UCIP Evaluation  
Crossing Status: Found  
UCIP Comments: 07/12/2021 The record remains Non-Urgent. WS pipe outlet is underwater, limited inspection. LS headwall and pipe inlets have human trash around and safety concerns to inspectors due to homeless encampments. Limited inspection on both WS due to water and LS due to safety concerns to the inspectors. The UCIP inspection was completed with GEI staff, P. Espinoza. (H. Dunn – GEI)10/27/2017 This structure is inspected annually under the Structure and Channel Summer Inspection (part of the Levee Inspection Program) conducted by the DWR Flood Project Integrity and Inspection Branch (FPIIB). (O. Magana - DWR UCIP)  
04/17/2014 Slide gates blocked by sediment. Recommend contacting owner to determine status of crossing. Crossing appears to be abandoned. (O. Magana - DWR UCIP)

LS view: Headwall visible at toe from crown.

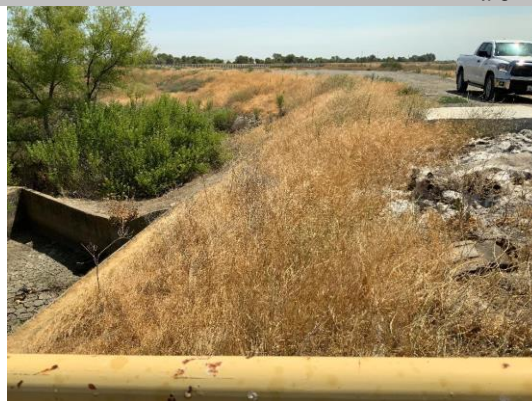
Photo 3 of 3 : UCIP\_FA\_2021\_68827\_101396.jpg

LS view: Slope from crown.

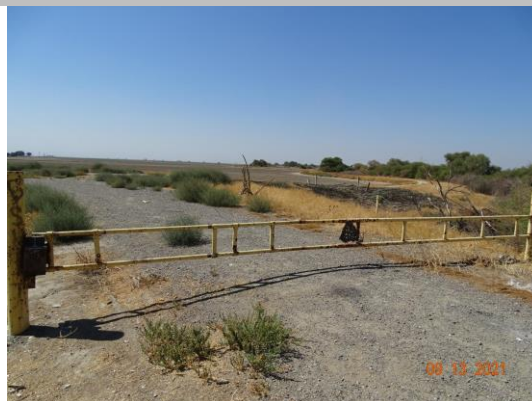
Photo 1 of 1 : FA\_2021\_NA0010\_122\_9\_20210929\_00023.jpg

LM Start	0.04	Rating **	U	Issue No.	9
LM End	0.04	Issue Type +	Ma	Location *	CR
Category	Earthen Levee			GPS Latitude/Longitude	
				Start	End
Item	Repair Gates			37.112335 °	37.112335 °
				-120.589622 °	-120.589622 °
DWR ID	DWR_NA0010_04_f _ 2021_9				
Comment Code					
Inspector Comment					
District lock has been removed. Cannot access through gate.

District lock has been removed from the gate. (Fall 2021)

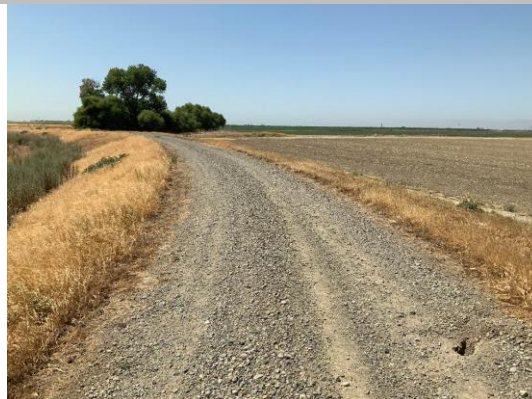
Photo 1 of 3 : UCIP\_FA\_2021\_67949\_101400.jpg

Comment Code						
Inspector Comment						
DS_ID:19564 FS_ID:67949 EP_NO: 4144 Repair Type: Non-Urgent EVAL Issue: Pipe Not Found Crossing Status: Not Found UCIP Comments: 06/9/2021 The record is Non-Urgent. Pipe not found during the in field inspection. Pipe not found by visual inspection. DWR DMP geophysical study did not confirm presence of pipe through levee. Record will remain in UCIP's inspection records until future Levee Improvement Project can confirm no crossing was found through the levee. The UCIP inspection was completed with GEI staff, P. Espinoza. (H. Dunn – GEI) FIELD_STRUCT_DESC: 36-inch corrugated metal gravity drainage pipe through the levee, 14.4 feet below the crown. Metal cutoff walls around pipe on both levee shoulders. Concrete headwall on the landside (LS) end. Concrete end wall on the waterside (WS) end. Flap gate on the WS end. (36-inch pipe through the levee authorized under Permit No. 4144, 1962 - Menefee River Ranch Company). FS Date: 7/12/2021

Levee crown.

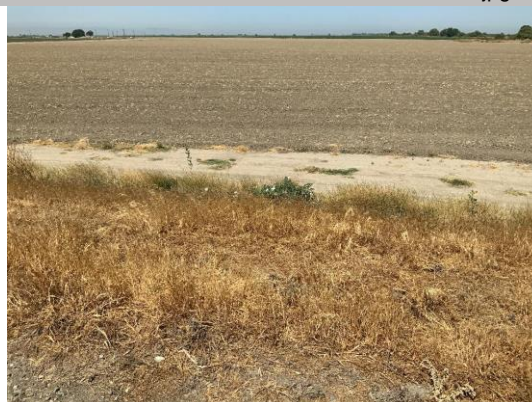
Photo 2 of 3 : UCIP\_FA\_2021\_67949\_101402.jpg

LS view: Toe from crown, no pipe visible.

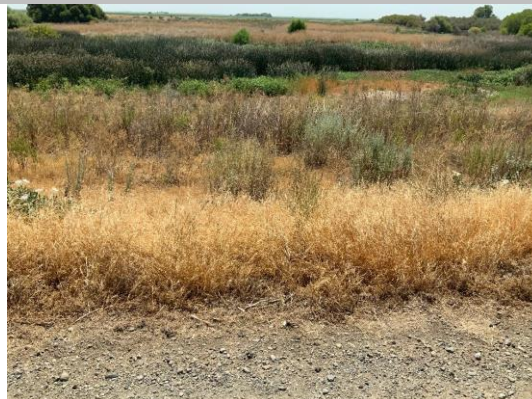
Photo 3 of 3 : UCIP\_FA\_2021\_67949\_101401.jpg

WS view: Toe from crown, no pipe visible.

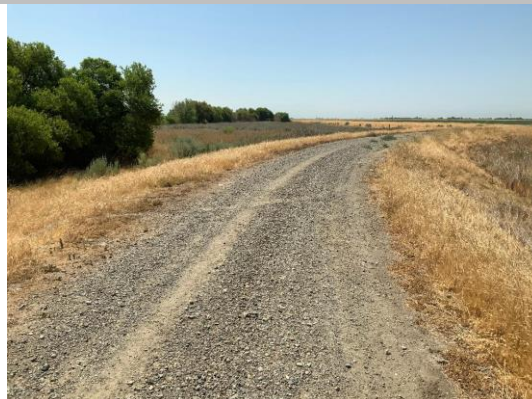
Photo 1 of 3 : UCIP\_FA\_2021\_68543\_101404.jpg

DS\_ID:19695  
FS\_ID:68543  
EP\_NO: N/A  
Repair Type: Non-Urgent  
EVAL Issue: Limited Inspection/No UCIP Evaluation  
Crossing Status: Found  
UCIP Comments: 07/12/2021 The record remains Non-Urgent. WS flapgate is underwater and covered by vegetation. LS inlet also covered by vegetation, recommend removal on both ends. No permit was found authorizing this encroachment. CVFPB will need to review crossing to determine owner. The UCIP inspection was completed with GEI staff, P. Espinoza. (H. Dunn – GEI) 04/17/2014 Sediment and debris blocking concrete headwall located on waterward side. During inspection water was flowing from landward side to waterward side. Recommend removing sediment to confirm condition of flap gate and pipe. (O. Magana - DWR UCIP)  
FIELD\_STRUCT\_DESC: 36-inch corrugated metal gravity drainage pipe through the levee, 18 feet below the crown. Flap gate on the waterside (WS) end. Concrete headwall on each end. [Additional Reference(s): DWR Levee Log, 2002[Additional Resource(s): DWR Levee Log, 2002 (HLM 0.03), listed as four 6-foot by 5-foot concrete culverts] (HLM 0.24), listed as a 36-inch corrugated metal pipe (CMP). USACE San Joaquin O&M Manual, Unit 601 Part 1 (SJR 601.1), 1967, Revised 25 May 2011, (HLM 0.27), listed as a 36-inch CMP].

Levee crown.

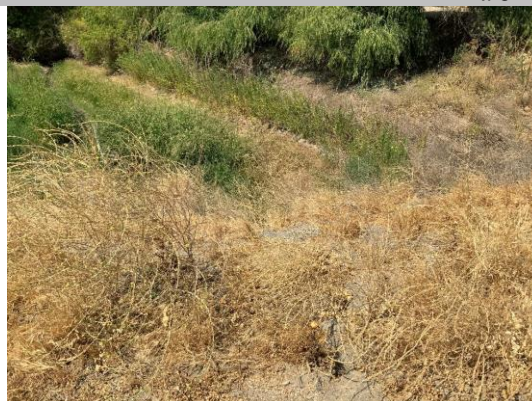
Photo 2 of 3 : UCIP\_FA\_2021\_68543\_101405.jpg

LS view: Toe from crown.

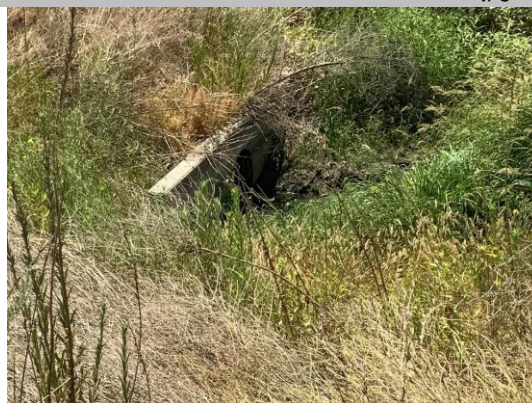
Photo 3 of 3 : UCIP\_FA\_2021\_68543\_101406.jpg

LS view: Pipe inlet with water in it at toe.

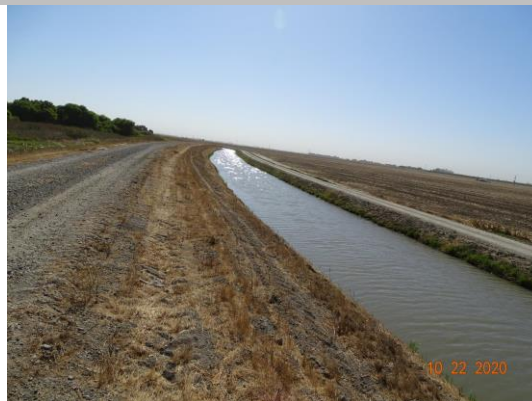
Photo 1 of 1 : FA\_2021\_NA0010\_122\_3\_20210830\_00001.jpg

LM Start	0.32	Rating **	M	Issue No.	3
LM End	1.41	Issue Type +	En	Location *	LS
Category	Earthen Levee			GPS Latitude/Longitude	
				Start	End
Item	Encroachments			37.108822 °	37.097556 °
				-120.590718 °	-120.578130 °
DWR ID	DWR_NA0010_04_s_2012_3				
Comment Code					
DT : Ditch					
Inspector Comment					
An irrigation ditch is within 10' easement.

Looking upstream at an irrigation ditch at the landside toe. (Fall 2020)

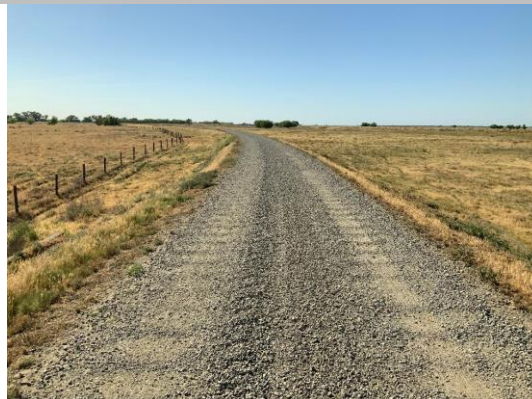
Photo 1 of 3 : UCIP\_FA\_2021\_70107\_99634.jpg

DS\_ID:19756  
FS\_ID:70107  
EP\_NO: N/A  
Repair Type: Non-Urgent  
EVAL Issue: Levee Damage or Threat for Levee Damage  
Crossing Status: Found  
UCIP Comments: 06/1/2021 Record remains Non-Urgent. DWR DMP internal inspection has not found pipe integrity issues. LOF of crossing is less or equal to 4.0. Recommend next video inspection in 5 years. Some soil sloughing/erosion on the WS slope. No permit was found authorizing this encroachment. CVFPB will need to review crossing to determine owner. The UCIP inspection was completed with GEI staff, P. Espinoza. (H. Dunn – GEI) 04/09/2014 Debris blocking landward headwall--recommend clearing. (W. Wylie - DWR UCIP)  
FIELD\_STRUCT\_DESC: 24-inch corrugated metal gravity drainage pipe through the levee, 8.6 feet below the crown. Concrete U-shaped headwall and flap gate on the waterside (WS) end. Concrete headwall on the landside (LS) end. [Additional Reference(s): DWR Levee Log, 2002 (HLM 0.07), listed as a 24-inch corrugated metal pipe [CMP]. USACE San Joaquin O&M Manual, Unit 601 Part 1 (SJR601.1), 1967, Revised 25 May 2011, (HLM 0.07), listed as a 24-inch CMP]

levee crown looking downstream.

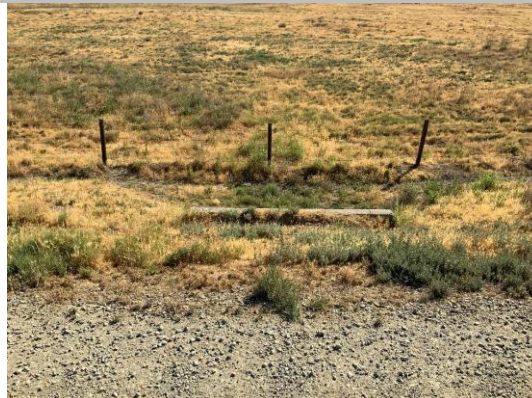
Photo 2 of 3 : UCIP\_FA\_2021\_70107\_99635.jpg

LS view: Headwall visible at toe from crown.

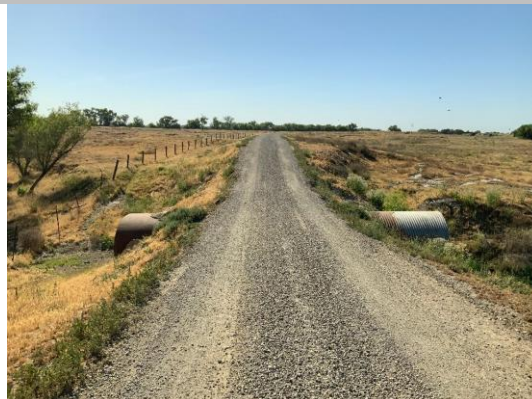
Photo 1 of 3 : UCIP\_FA\_2021\_70177\_99641.jpg

Comment Code					
Inspector Comment					
DS_ID:24867 FS_ID:70177 EP_NO: N/A Repair Type: Urgent EVAL Issue: Levee Integrity Crossing Status: Found UCIP Comments: 06/1/2021 Record remains Urgent. Same as previous inspection comments. There is no flapgate, the pipe is open on both ends. Pipe is being bent down from the top. Crown has subsided about 4 feet from the original crown. Minor erosion around pipe on both WS and LS. No permit was found authorizing this encroachment. CVFPB will need to review crossing to determine owner. The UCIP inspection was completed with GEI staff, P. Espinoza. (H. Dunn – GEI)  11/01/2018 Same as previous inspection, 1960s levee breach; degraded levee section that drops about 4 feet within a 100-foot levee section. Crossing remains Urgent due to the levee degradation at this location. (O. Magana - DWR UCIP)07/20/2016 same as previous inspection. Levee section at crossing has been degraded. According to LMA representative, Rick, the low point at crossing has been present for over 10 years when the pipe was replaced. (O. Magana - DWR UCIP)04/09/2014 Pipe is open on both ends and levee has been degraded at this location. No permit identified for this crossing. (W. Wylie - DWR UCIP) FIELD_STRUCT_DESC: 96-inch corrugated metal gravity drainage pipe through the levee, 4.5 feet below the crown. Pipe is composed of two materials: corrugated metal pipe (CMP) on the waterside (WS) and steel pipe on the landside (LS). This section of the levee is a degraded section that drops approximately 4 feet within 100 feet of length. This section of the levee is the site of the 1960s levee breach. [Additional Reference(s): USACE Periodic Inspection Report 2014, USACE_CESPK_L05A_2014_p_0014]. FS Date: 6/1/2021

Levee crown looking downstream. Crown is lower above pipe.

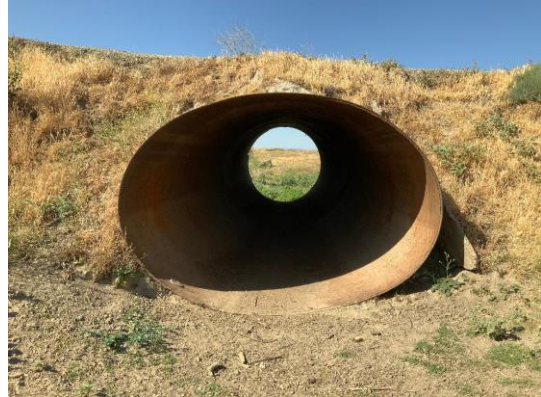
Photo 2 of 3 : UCIP\_FA\_2021\_70177\_99642.jpg

LS view: Slope and pipe inlet, top being bent down from toe.

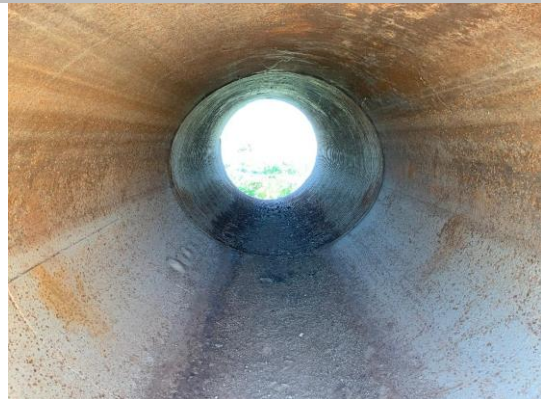
Photo 3 of 3 : UCIP\_FA\_2021\_70177\_99643.jpg

LS view: Inside pipe inlet at toe.

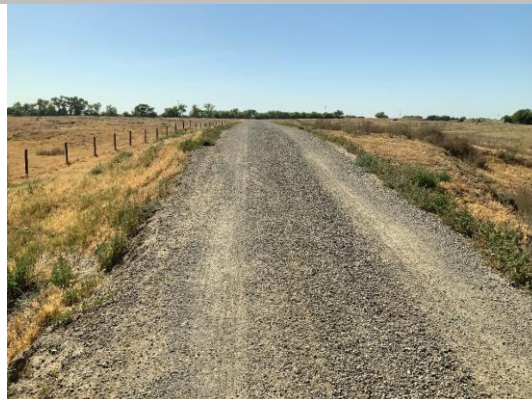
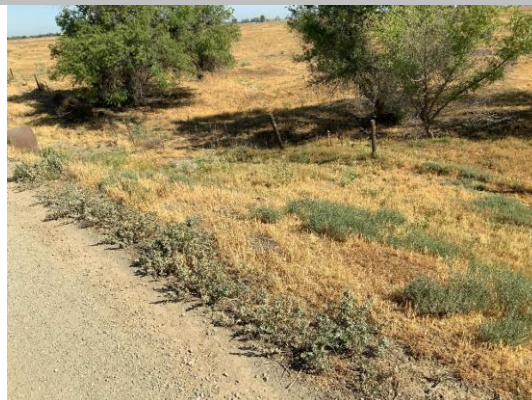
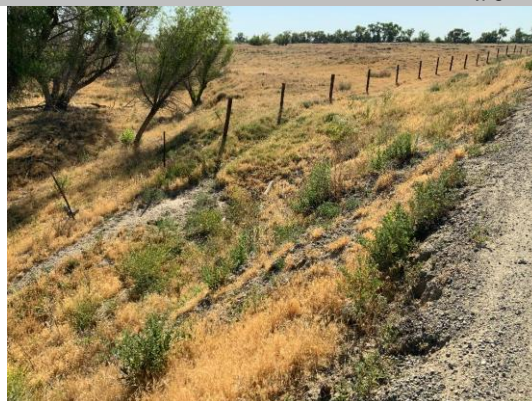
Comment Code						
Inspector Comment						
DS_ID:19557 FS_ID:69869 EP_NO: N/A Repair Type: Non-Urgent EVAL Issue: Pipe Not Found Crossing Status: Not Found UCIP Comments: 06/1/2021 Record remains Non-Urgent. Pipe not found by visual inspection. No permit was found authorizing this encroachment. CVFPB will need to review crossing to determine owner. The UCIP inspection was completed with GEI staff, P. Espinoza. (H. Dunn – GEI)11/01/2018 24-inch corrugated metal pipe (CMP) section found during pipe inspection of dsid 24867 (see photos); according to LMA representative levee section is the location of levee breach from 1960s; 24-inch pipe was undersized and was replaced after levee breach with a 96-inch CMP and steel pipe. (O. Magana - DWR UCIP) FIELD_STRUCT_DESC: 24-inch corrugated metal gravity drainage pipe through the levee, 5.6 feet below the crown. Flap gate on the waterside (WS) end. Large pipe found at this location. [Additional Reference(s): USACE San Joaquin O&M Manual, Unit 601 Part 1 (SJR601.1), 1967, Revised 25 May 2011, (HLM 0.30), listed as a 24-inch corrugated metal pipe (CMP)] FS Date: 6/1/2021

LS view: Slope and toe from crown, no pipe visible.

LS view: Toe from crown, no pipe visible.

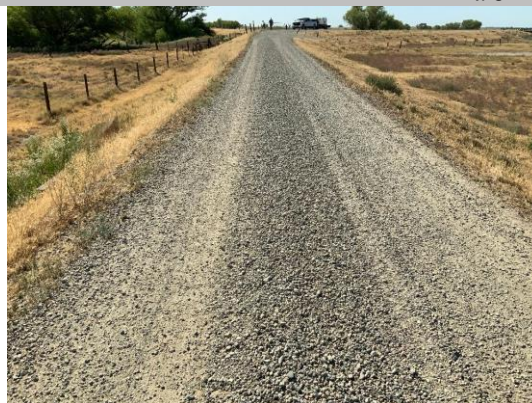
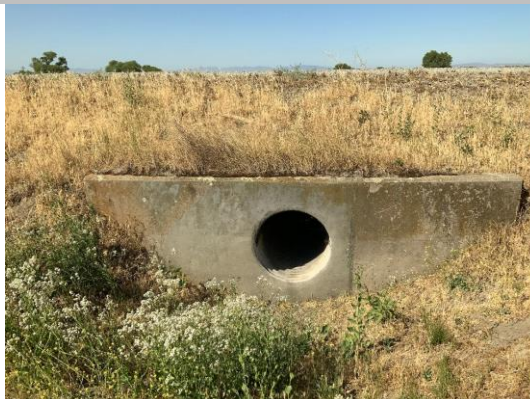
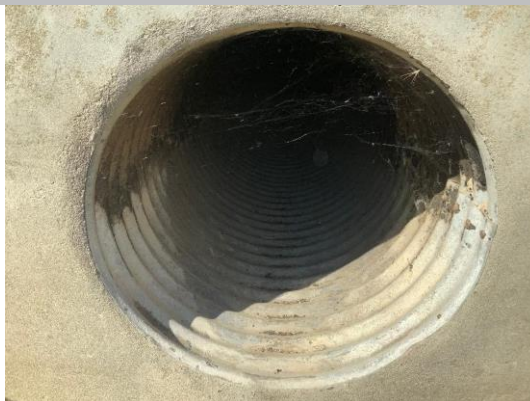
DS\_ID:19757  
 FS\_ID:70109  
 EP\_NO: N/A  
 Repair Type: Non-Urgent  
 EVAL Issue: Pipe Damage  
 Crossing Status: Found  
 UCIP Comments: 06/1/2021 Record remains Non-Urgent. DWR DMP internal inspection has found pipe integrity issues. LOF of crossing is greater than or equal to 4.1 and less than 5. Crossing will be monitored until funding becomes available for rehabilitation. No permit was found authorizing this encroachment. CVFPB will need to review crossing to determine owner. The UCIP inspection was completed with GEI staff, P. Espinoza. (H. Dunn – GEI) 04/09/2014 Excess debris on landward headwall--recommend clearing. (W. Wylie - DWR UCIP)  
 FIELD\_STRUCT\_DESC: 30-inch corrugated metal gravity drainage pipe through the levee, 7.5 feet below the crown. Flap gate on the waterside (WS) end. Concrete headwall on the landside (LS) end. Concrete U-shaped headwall on the WS end. [Additional Reference(s): DWR Levee Log, 2002 (HLM 0.58), listed as a 30-inch corrugated metal pipe (CMP). USACE San Joaquin O&M Manual, Unit 601 Part 1 (SJR601.1), 1967, Revised 25 May 2011, (HLM 0.59), listed as a 30-inch CMP]

LS view: Slope and headwall from toe.

LS view: Close up of pipe inlet at toe.

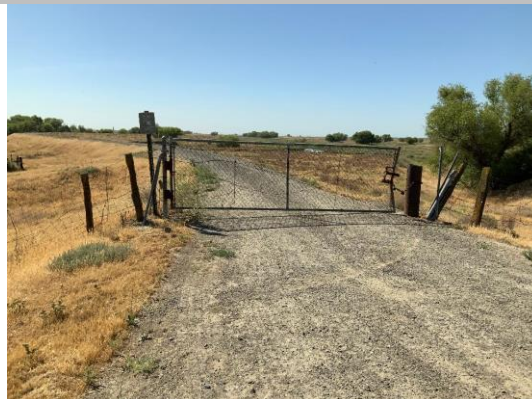
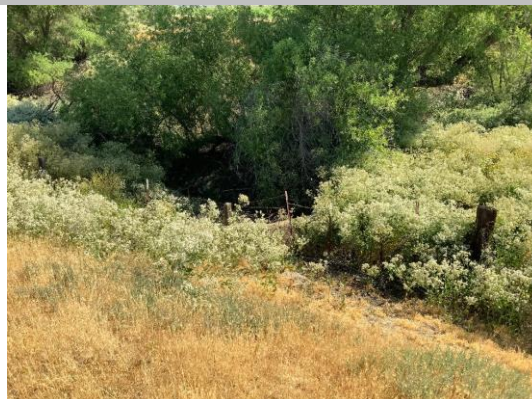
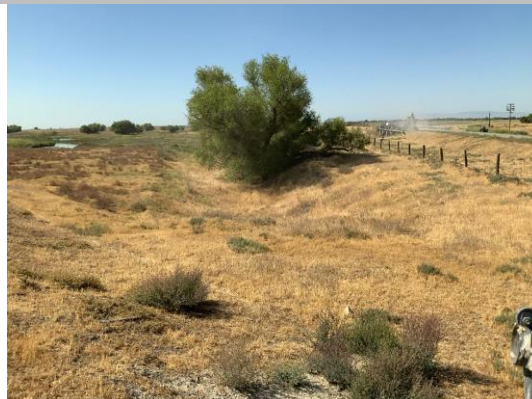
DS\_ID:19758  
FS\_ID:70049  
EP\_NO: N/A  
Repair Type: Urgent  
EVAL Issue: Pipe Integrity  
Crossing Status: Found  
UCIP Comments: 06/1/2021 Record has been upgraded from Non-Urgent to Urgent. DWR DMP internal inspection has found pipe integrity issues. LOF of crossing is greater than or equal to 5 and less than 6. Crossing will be monitored until funding becomes available to address the issues. No closeup inspection of LS pipe end due to dense vegetation and barbed wire. No permit was found authorizing this encroachment. CVFPB will need to review crossing to determine owner. The UCIP inspection was completed with GEI staff, P. Espinoza. (H. Dunn – GEI)04/09/2014 Dense vegetation limits the inspector's visibility to identify signs of pipe failure (leaks) along the landward slope. Recommend removing vegetation along pipe alignment to conduct proper inspection of structure. (W. Wylie - DWR UCIP)

LS view: Headwall barely visible at toe from crown.

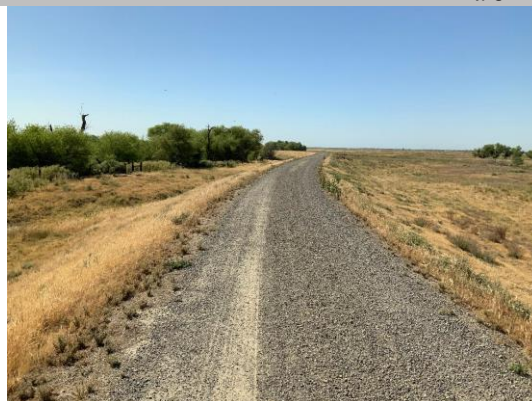
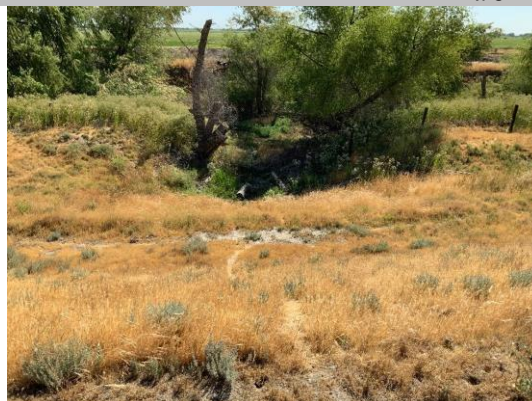
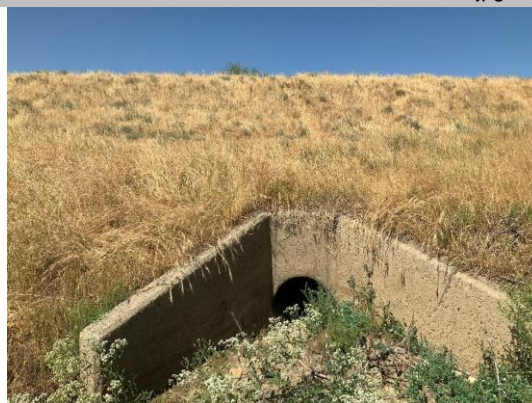
DS\_ID:19759  
FS\_ID:70050  
EP\_NO: N/A  
Repair Type: Urgent  
EVAL Issue: Pipe Integrity  
Crossing Status: Found  
UCIP Comments: 06/1/2021 Record has been upgraded from No Action Needed to Urgent. DWR DMP internal inspection has found pipe integrity issues. LOF of crossing is greater than or equal to 5 and less than 6. Crossing will be monitored until funding becomes available to address the issues. No permit was found authorizing this encroachment. CVFPB will need to review crossing to determine owner. The UCIP inspection was completed with GEI staff, P. Espinoza. (H. Dunn – GEI)  
FIELD\_STRUCT\_DESC: 24-inch corrugated metal gravity drainage pipe through the levee, 14.4 feet below the crown. Flap gate on the waterside (WS) end. Concrete headwall on the landside (LS) end. Concrete U-shaped headwall on the WS end. [Additional Reference(s): DWR Levee Log, 2002 (HLM 0.84), listed as a 24-inch corrugated metal pipe (CMP). USACE San Joaquin O&M Manual, Unit 601 Part 1 (SJR601.1), 1967, Revised 25 May 2011, (HLM 0.84), listed as a 24-inch CMP]

LS view: Slope and headwall at toe.

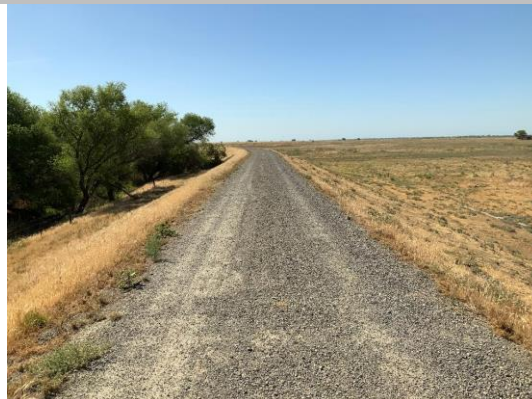
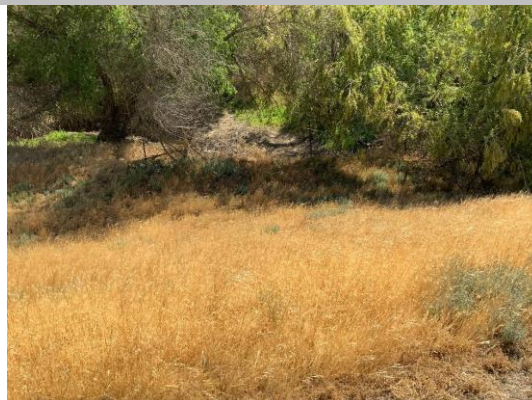
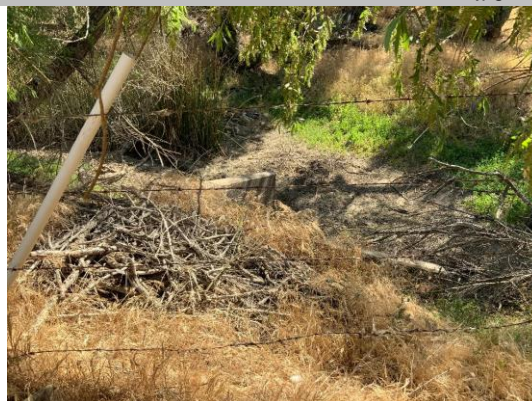
Comment Code					
Inspector Comment					
DS_ID:19760 FS_ID:70110 EP_NO: N/A Repair Type: Non-Urgent EVAL Issue: Limited Inspection/No UCIP Evaluation Crossing Status: Found UCIP Comments: 06/1/2021 The record has been upgraded from No Action Needed to Non-Urgent. LS pipe inlet blocked by barbed wire, could not inspect. Small pipe lodged in the WS flapgate so it cannot be closed all the way, recommend removal before flood season. No permit was found authorizing this encroachment. CVFPB will need to review crossing to determine owner. The UCIP inspection was completed with GEI staff, P. Espinoza. (H. Dunn – GEI) FIELD_STRUCT_DESC: 36-inch corrugated metal gravity drainage pipe through the levee, 21 feet below the crown. Flap gate on the waterside (WS) end. Concrete headwall on the landside (LS) end. Concrete U-shaped headwall on the WS end. [Additional Reference(s): DWR Levee Log, 2002 (HLM 1.44), listed as a 36-inch corrugated metal pipe (CMP). USACE San Joaquin O&M Manual, Unit 601 Part 1 (SJR601.1), 1967, Revised 25 May 2011, (HLM 1.44), listed as a 36-inch CMP] FS Date: 6/1/2021

LS view: Headwall barely visible at toe behind barbed wire.

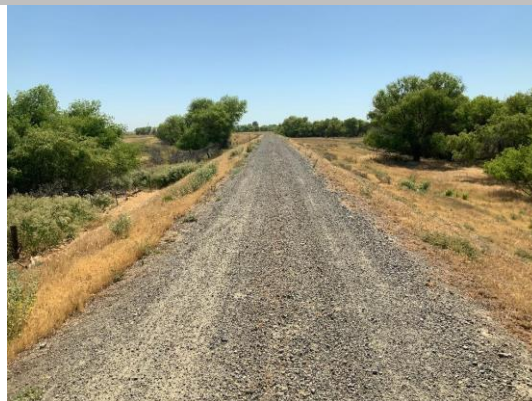
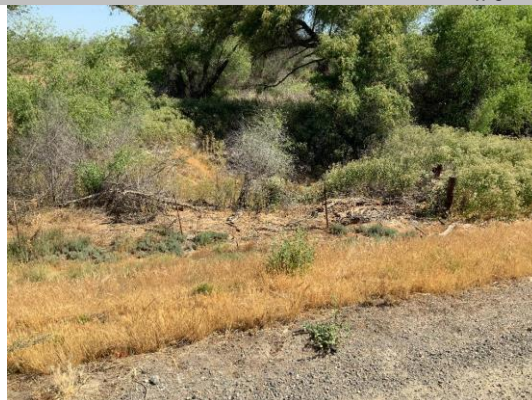
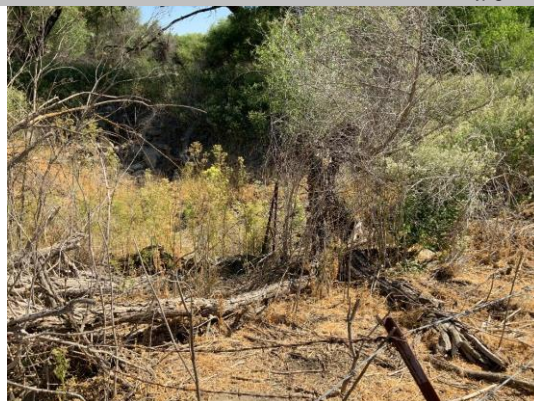
Comment Code					
Inspector Comment					
DS_ID:19809 FS_ID:70111 EP_NO: N/A Repair Type: Non-Urgent EVAL Issue: Pipe Damage Crossing Status: Found UCIP Comments: 06/1/2021 Record remains Non-Urgent. DWR DMP internal inspection has found pipe integrity issues. LOF of crossing is between 4.1 and 5. Crossing will be monitored until funding becomes available for rehabilitation. Barbed wire over LS end, could not inspect. No permit was found authorizing this encroachment. CVFPB will need to review crossing to determine owner. The UCIP inspection was completed with GEI staff, P. Espinoza. (H. Dunn – GEI) 04/09/2014 Log partially blocking inlet at LS toe. (W. Wylie - DWR UCIP) FIELD_STRUCT_DESC: 24-inch corrugated metal gravity drainage pipe through the levee, 15 feet below the crown. Flap gate on the waterside (WS) end. Concrete U-shaped headwall on each end. [Additional Reference(s): DWR Levee Log, 2002 (HLM 2.83), listed as a 24-inch corrugated metal pipe (CMP). USACE San Joaquin O&M Manual, Unit 601 Part 1 (SJR601.1), 1967, Revised 25 May 2011, (HLM 2.85), listed as a 24-inch CMP] FS Date: 6/1/2021

LS view: Headwall barely visible at toe behind barbed wire.

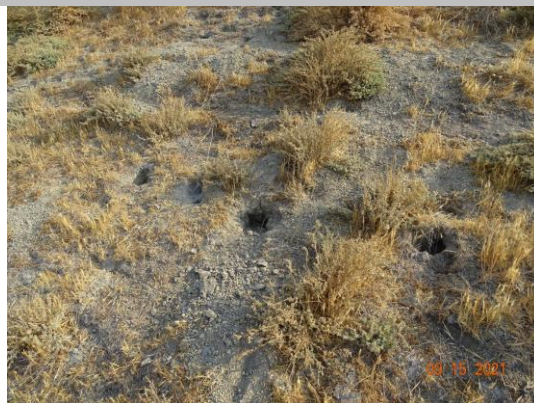
Photo 1 of 1 : FA\_2021\_NA0010\_123\_127\_20210929\_00334.jpg

LM Start	3.23	Rating **	A/W	Issue No.	127
LM End	3.23	Issue Type +	Ma	Location *	WS
Category	Earthen Levee			GPS Latitude/Longitude	
				Start	End
Item	Animal Control			37.256278 °	37.256278 °
				-120.778404 °	-120.778404 °
DWR ID	DWR_NA0010_05_f_2018_127				
Comment Code					
A3 : No rodents visible, but rodent burrows visible; need to backfill and compact or grout burrows.					
Inspector Comment

View of rodent holes in the water side slope. (Fall 2021)

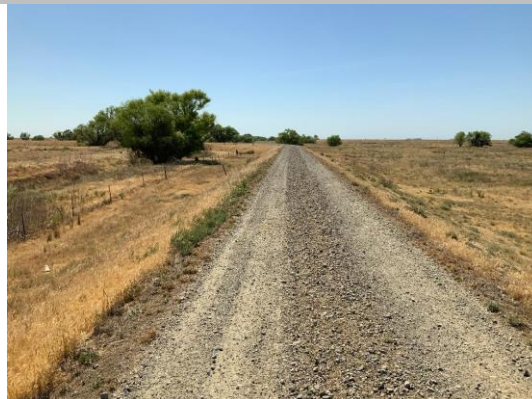
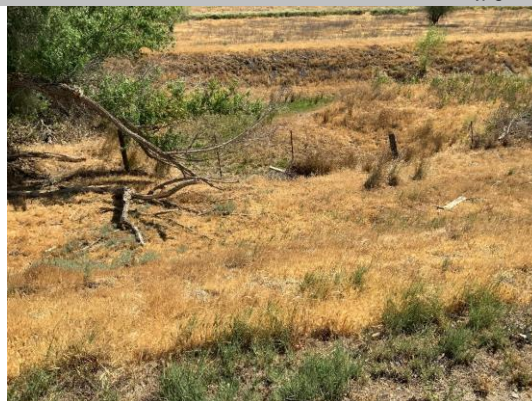
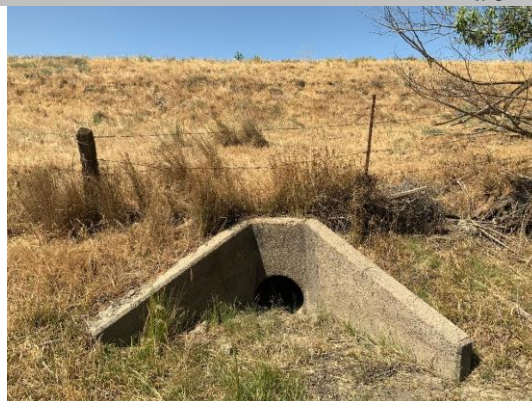
DS\_ID:19810  
FS\_ID:70112  
EP\_NO: N/A  
Repair Type: Non-Urgent  
EVAL Issue: Pipe Damage  
Crossing Status: Found  
UCIP Comments: 06/1/2021 Record remains Non-Urgent. DWR DMP internal inspection has found pipe integrity issues. LOF of crossing is between 4.1 and 5. Crossing will be monitored until funding becomes available for rehabilitation. Pipe is eroded through causing holes just behind the WS flapgate. Metal peeling away inside of pipe outlet. Flapgate is rusted with some corrosion. No permit was found authorizing this encroachment. CVFPB will need to review crossing to determine owner. The UCIP inspection was completed with GEI staff, P. Espinoza. (H. Dunn – GEI) 04/15/2014 Pipe corroded through at flapgate on WS toe. (W. Wylie - DWR UCIP)  
FIELD\_STRUCT\_DESC: 24-inch corrugated metal gravity drainage pipe through the levee, 14.7 feet below the crown. Flap gate on the waterside (WS) end. Concrete U-shaped headwall on each end.

LS view: Slope and headwall at toe.

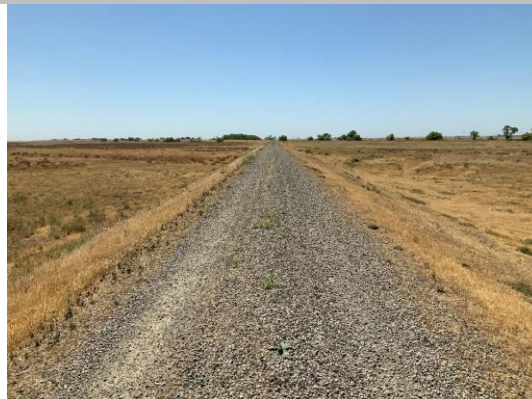
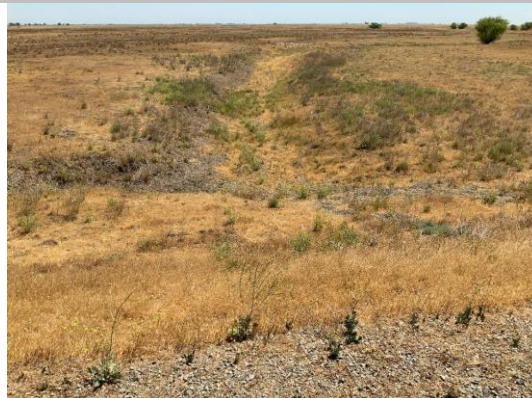
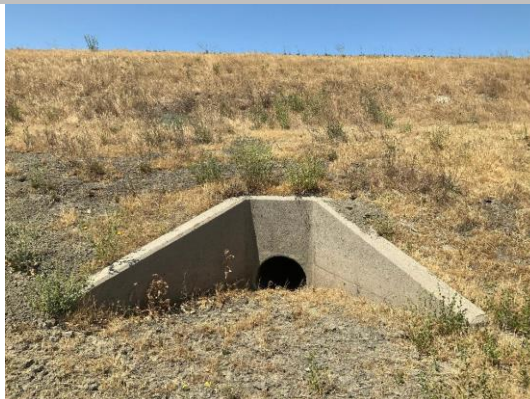
DS\_ID:19811  
FS\_ID:70113  
EP\_NO: N/A  
Repair Type: Non-Urgent  
EVAL Issue: Maintenance Compliance Issue  
Crossing Status: Found  
UCIP Comments: 06/1/2021 Record remains Non-Urgent. Some debris buildup within the LS pipe inlet, recommend cleaning out. No permit was found authorizing this encroachment. CVFPB will need to review crossing to determine owner. The UCIP inspection was completed with GEI staff, P. Espinoza. (H. Dunn – GEI) 04/16/2014 Sediment buildup in pipe visible from landward side--recommend contacting owner to clear pipe. (W. Wylie - DWR UCIP)  
FIELD\_STRUCT\_DESC: 24-inch corrugated metal gravity drainage pipe through the levee, 15 feet below the crown. Flap gate on the waterside (WS) end. Concrete headwall on the landside (LS) end. Concrete U-shaped headwall on the WS end. [Additional Reference(s): DWR Levee Log, 2002 (HLM 3.67), listed as a 24-inch corrugated metal pipe (CMP). USACE San Joaquin O&M Manual, Unit 601 Part 1 (SJR601.1), 1967, Revised 25 May 2011, (HLM 3.67), listed as a 24-inch CMP]

LS view: Slope and headwall at toe.

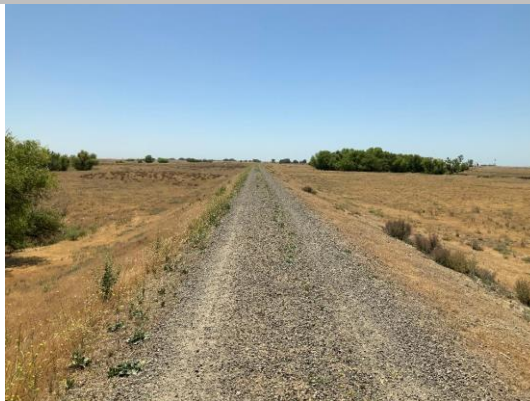
Photo 1 of 3 : UCIP\_FA\_2021\_70114\_99704.jpg

DS\_ID:19769  
 FS\_ID:70114  
 EP\_NO: N/A  
 Repair Type: Non-Urgent  
 EVAL Issue: Maintenance Compliance Issue  
 Crossing Status: Found  
 UCIP Comments: 06/1/2021 Record remains Non-Urgent. Some sediment buildup in LS pipe inlet, recommend cleaning out. No permit was found authorizing this encroachment. CVFPB will need to review crossing to determine owner. The UCIP inspection was completed with GEI staff, P. Espinoza. (H. Dunn – GEI) 04/16/2014 Sediment buildup in pipe visible from landward side--recommend contacting owner to clear pipe. (W. Wylie - DWR UCIP)  
 FIELD\_STRUCT\_DESC: 24-inch corrugated metal gravity drainage pipe through the levee, 16 feet below the crown. Flap gate on the waterside (WS) end. Concrete U-shaped headwall on each end.  
 [Additional Reference(s): DWR Levee Log, 2002 (HLM 4.01), listed as a 24-inch corrugated metal pipe (CMP). USACE San Joaquin O&M Manual, Unit 601 Part 1 (SJR601.1), 1967, Revised 25 May 2011, (HLM 4.02), listed as a 24-inch CMP]

Levee crown looking downstream.

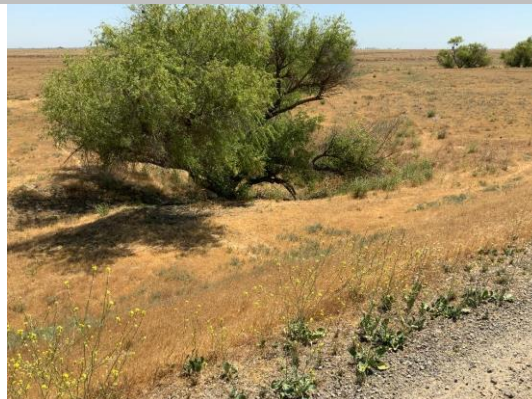
Photo 2 of 3 : UCIP\_FA\_2021\_70114\_99701.jpg

LS view: Toe from crown.

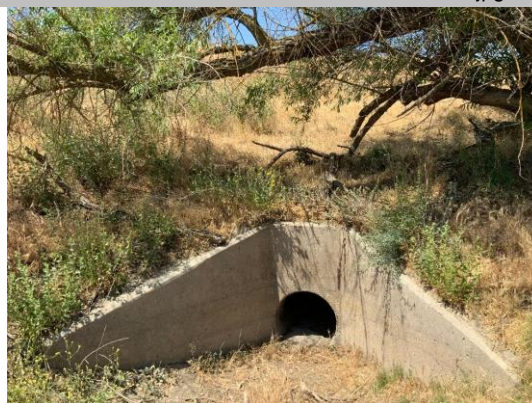
Photo 3 of 3 : UCIP\_FA\_2021\_70114\_99702.jpg

LS view: Slope and headwall at toe.

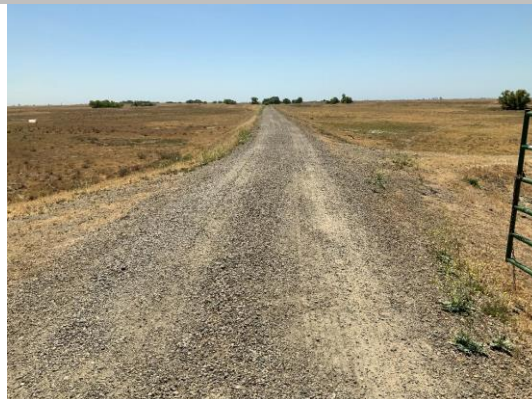
Photo 1 of 3 : UCIP\_FA\_2021\_69872\_99711.jpg

DS\_ID:19770  
FS\_ID:69872  
EP\_NO: N/A  
Repair Type: Non-Urgent  
EVAL Issue: Maintenance Compliance Issue  
Crossing Status: Found  
UCIP Comments: 06/1/2021 Record remains Non-Urgent. Sizable burrow complex on WS slope, with several holes around 3-4 inches wide, recommend filling in for levee integrity. There is also sediment buildup within the LS pipe inlet, recommend cleaning out. No permit was found authorizing this encroachment. CVFPB will need to review crossing to determine owner. The UCIP inspection was completed with GEI staff, P. Espinoza. (H. Dunn – GEI) 04/16/2014 Sediment buildup in pipe visible from landward side--recommend contacting owner to clear pipe. (W. Wylie - DWR UCIP)  
FIELD\_STRUCT\_DESC: 24-inch corrugated metal gravity drainage pipe through the levee, 11.6 feet below the crown. Flap gate on the waterside (WS) end. Concrete headwall on the landside (LS) end. Concrete U-shaped headwall on the WS end. [Additional Reference(s): DWR Levee Log, 2002 (HLM 4.27), listed as a 24-inch corrugated metal pipe (CMP). USACE San Joaquin O&M Manual, Unit 601 Part 1 (SJR601.1), 1967, Revised 25 May 2011, (HLM 4.27), listed as a 24-inch CMP]

Levee crown looking downstream.

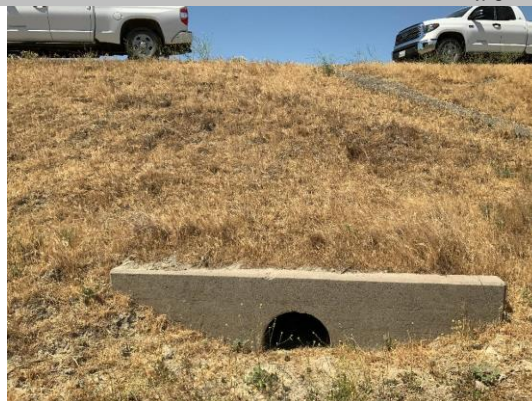
Photo 2 of 3 : UCIP\_FA\_2021\_69872\_99714.jpg

LS view: Slope and headwall at toe.

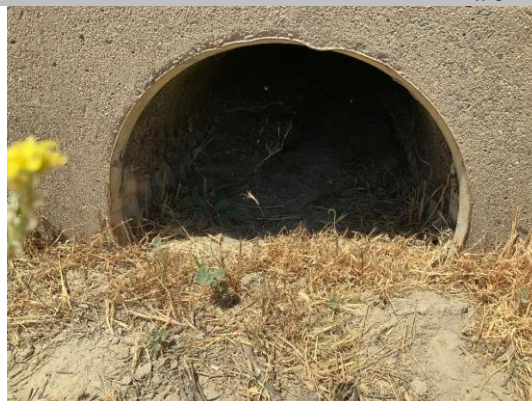
Photo 3 of 3 : UCIP\_FA\_2021\_69872\_99715.jpg

LS view: Close up of pipe inlet with sediment buildup at toe.

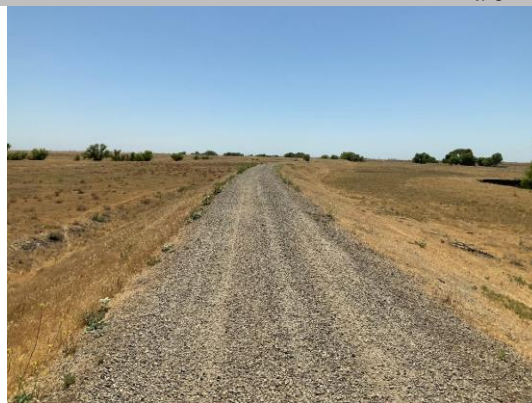
Photo 1 of 3 : UCIP\_FA\_2021\_69873\_99719.jpg

Comment Code						
Inspector Comment						
DS_ID:19771 FS_ID:69873 EP_NO: N/A Repair Type: Non-Urgent EVAL Issue: Maintenance Compliance Issue Crossing Status: Found UCIP Comments: 06/1/2021 Record remains Non-Urgent. LS pipe inlet has sediment buildup inside, recommend cleaning out. No permit was found authorizing this encroachment. CVFPB will need to review crossing to determine owner. The UCIP inspection was completed with GEI staff, P. Espinoza. (H. Dunn – GEI) 04/16/2014 Sediment buildup in pipe visible from landward side--recommend contacting owner to clear pipe. (W. Wylie - DWR UCIP) FIELD_STRUCT_DESC: 24-inch corrugated metal gravity drainage pipe through the levee, 12 feet below the crown. Flap gate on the waterside (WS) end. Concrete headwall on the landside (LS) end. Concrete U-shaped headwall on the WS end. [Additional Reference(s): DWR Levee Log, 2002 (HLM 4.53), listed as a 24-inch corrugated metal pipe (CMP). USACE San Joaquin O&M Manual, Unit 601 Part 1 (SJR601.1), 1967, Revised 25 May 2011, (HLM 4.54), listed as a 24-inch CMP] FS Date: 6/1/2021

Levee crown looking downstream.

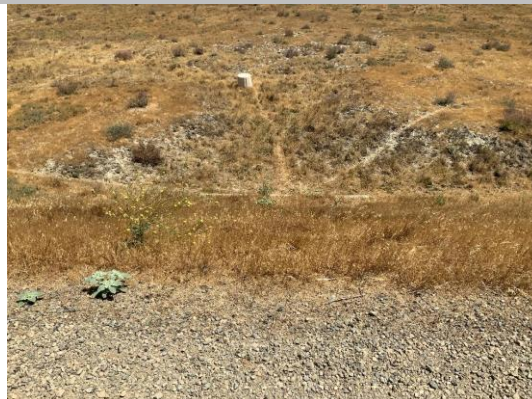
Photo 2 of 3 : UCIP\_FA\_2021\_69873\_99723.jpg

LS view: Toe from crown.

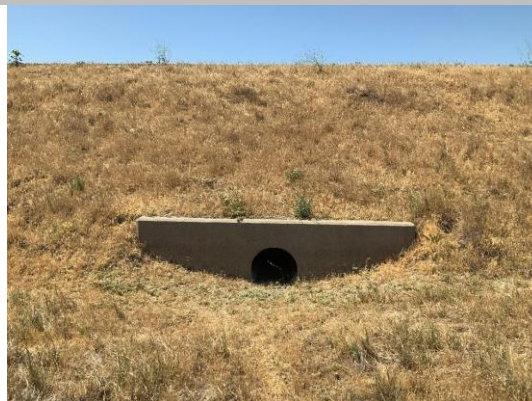
Photo 3 of 3 : UCIP\_FA\_2021\_69873\_99717.jpg

LS view: Slope and headwall at toe.

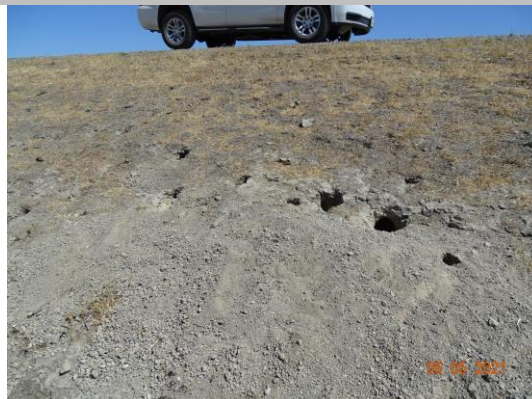
Photo 1 of 1 : FA\_2021\_NA0010\_123\_100\_20210830\_00010.jpg

LM Start	4.85	Rating **	M	Issue No.	100
LM End	4.85	Issue Type +	Ma	Location *	WS
Category	Earthen Levee			GPS Latitude/Longitude	
				Start	End
Item	Animal Control			37.241127 °	37.241127 °
				-120.752398 °	-120.752398 °
DWR ID	DWR_NA0010_05_s_2021_100				
Comment Code					
A1 : Exterminate rodents and backfill and compact or grout burrows.					
Inspector Comment					
Several burrows and rodents observed at this location. Bait stations have been set up.

Several rodent burrows noted at this location. (Spring 2021)

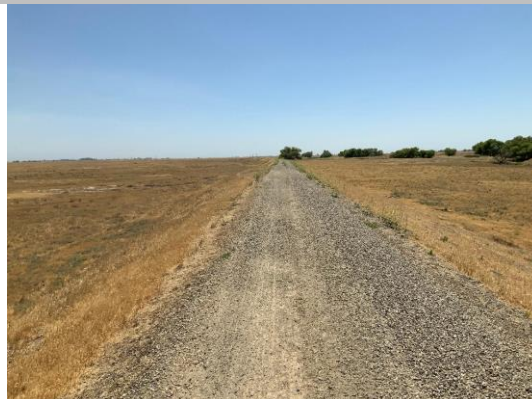
Photo 1 of 3 : UCIP\_FA\_2021\_67750\_100749.jpg

Comment Code					
Inspector Comment					
DS_ID:19772 FS_ID:67750 EP_NO: N/A Repair Type: Non-Urgent EVAL Issue: Maintenance Compliance Issue Crossing Status: Found UCIP Comments: 06/1/2021 The record remains Non-Urgent. LS pipe inlet has sediment buildup, recommend cleaning out. No permit was found authorizing this encroachment. CVFPB will need to review crossing to determine owner. The UCIP inspection was completed with GEI staff, P. Espinoza. (H. Dunn – GEI) 04/16/2014 Heavy sediment buildup in pipe visible from landward side--recommend contacting owner to clear pipe. (W. Wylie - DWR UCIP) FIELD_STRUCT_DESC: 24-inch corrugated metal gravity drainage pipe through the levee, 12.3 feet below the crown. Flap gate on the waterside (WS) end. Concrete headwall on the landside (LS) end. Concrete U-shaped headwall on the WS end. [Additional Reference(s): DWR Levee Log, 2002 (HLM 4.89), listed as a 24-inch corrugated metal pipe (CMP). USACE San Joaquin O&M Manual, Unit 601 Part 1 (SJR601.1), 1967, Revised 25 May 2011, (HLM 4.89), listed as a 24-inch CMP] FS Date: 6/1/2021

Levee crown looking downstream.

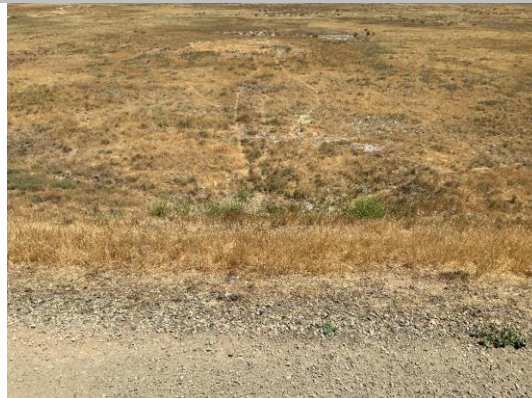
Photo 2 of 3 : UCIP\_FA\_2021\_67750\_100753.jpg

LS view: Toe from crown.

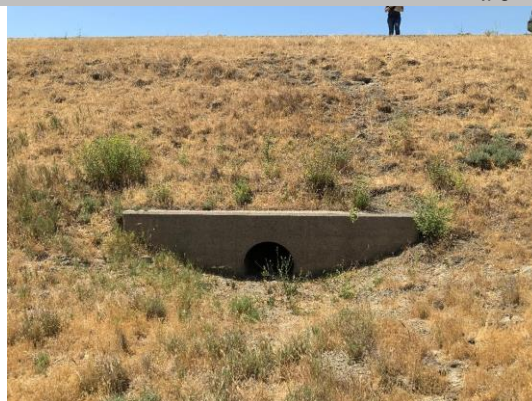
Photo 3 of 3 : UCIP\_FA\_2021\_67750\_100747.jpg

LS view: Slope and headwall at toe.

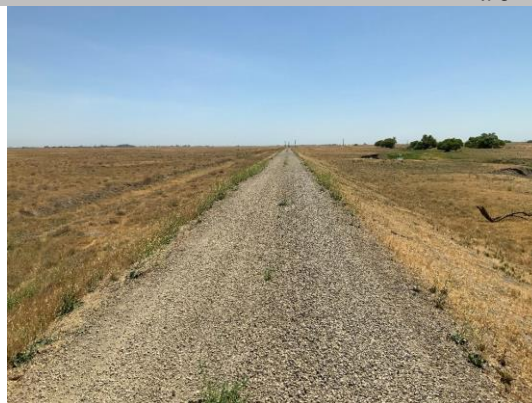
Photo 1 of 3 : UCIP\_FA\_2021\_70178\_100756.jpg

DS\_ID:19773  
 FS\_ID:70178  
 EP\_NO: N/A  
 Repair Type: Non-Urgent  
 EVAL Issue: Unauthorized Encroachment, installed decades prior  
 Crossing Status: Found  
 UCIP Comments: 06/1/2021 The record remains Non-Urgent. Crossing appears to be in good condition. No permit was found authorizing this encroachment. CVFPB will need to review crossing to determine owner. The UCIP inspection was completed with GEI staff, P. Espinoza. (H. Dunn – GEI) 04/16/2014 Heavy sediment buildup in pipe visible from landward side--recommend contacting owner to clear pipe. (W. Wylie - DWR UCIP)  
 FIELD\_STRUCT\_DESC: 24-inch corrugated metal gravity drainage pipe through the levee, 12.2 feet below the crown. Flap gate on the waterside (WS) end. Concrete headwall on the landside (LS) end. Concrete U-shaped headwall on the WS end. [Additional Reference(s): DWR Levee Log, 2002 (HLM 5.14), listed as a 24-inch corrugated metal pipe (CMP). USACE San Joaquin O&M Manual, Unit 601 Part 1 (SJR601.1), 1967, Revised 25 May 2011, (HLM 5.15), listed as a 24-inch CMP]

Levee crown looking upstream.

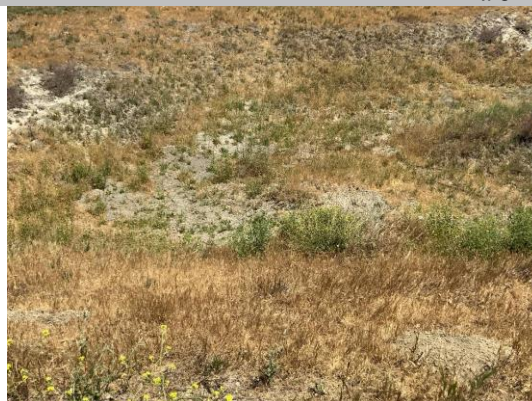
Photo 2 of 3 : UCIP\_FA\_2021\_70178\_100760.jpg

LS view: Toe from crown.

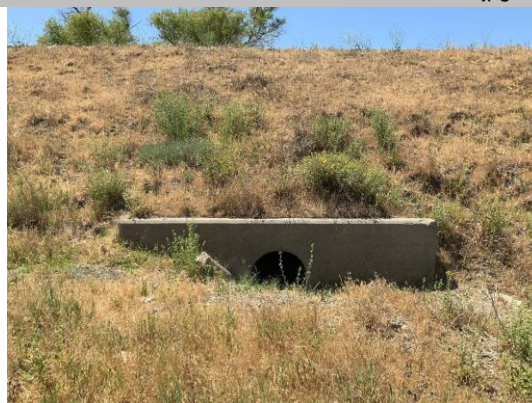
Photo 3 of 3 : UCIP\_FA\_2021\_70178\_100754.jpg

LS view: Slope and headwall at toe.

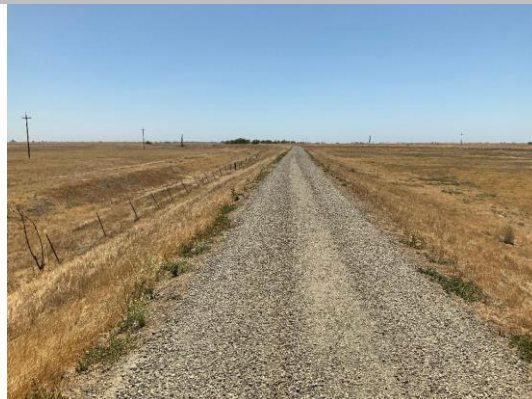
Photo 1 of 3 : UCIP\_FA\_2021\_70179\_100766.jpg

DS\_ID:19774  
FS\_ID:70179  
EP\_NO: N/A  
Repair Type: Non-Urgent  
EVAL Issue: Unauthorized Encroachment, installed decades prior  
Crossing Status: Found  
UCIP Comments: 06/1/2021 The record has been upgraded from No Action Needed to Non-Urgent. Crossing appears to be in good condition. No permit was found authorizing this encroachment. CVFPB will need to review crossing to determine owner. New concrete riser, plastic riser, and flowmeter off the LS toe going away from the levee. The UCIP inspection was completed with GEI staff, P. Espinoza. (H. Dunn – GEI)  
FIELD\_STRUCT\_DESC: 24-inch corrugated metal gravity drainage pipe through the levee, 9.5 feet below the crown. Flap gate on the waterside (WS) end. Concrete headwall on the landside (LS) end. Concrete U-shaped headwall on the WS end. [Additional Reference(s): DWR Levee Log, 2002 (HLM 5.58), listed as a 24-inch corrugated metal pipe (CMP). USACE San Joaquin O&M Manual, Unit 601 Part 1 (SJR601.1), 1967, Revised 25 May 2011, (HLM 5.58), listed as a 24-inch CMP]

Levee crown looking upstream.

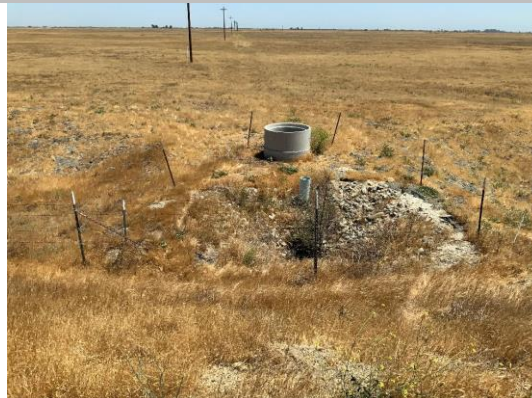
Photo 2 of 3 : UCIP\_FA\_2021\_70179\_100768.jpg

LS view: Toe from crown.

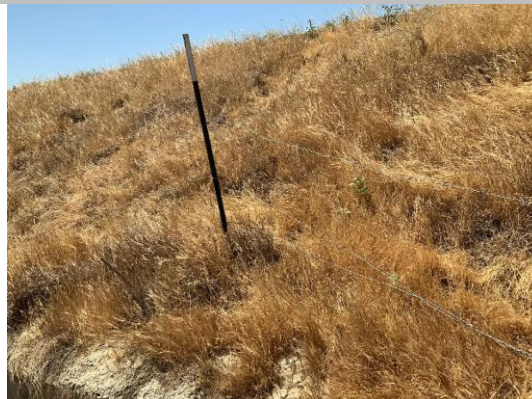
Photo 3 of 3 : UCIP\_FA\_2021\_70179\_100769.jpg

LS view: Slope from toe.

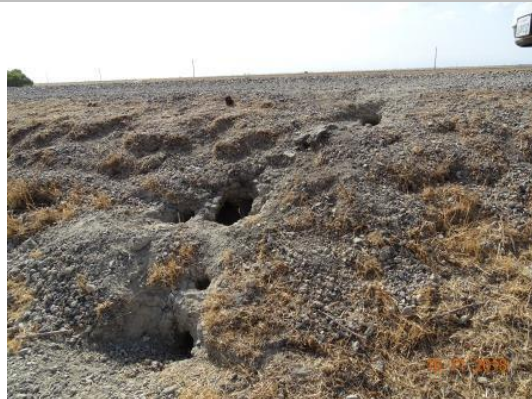
Photo 1 of 1 : FA\_2021\_NA0010\_123\_138\_20210830\_00034.jpg

LM Start	5.94	Rating **	U	Issue No.	138
LM End	5.94	Issue Type +	Ma	Location *	LS
Category	Earthen Levee			GPS Latitude/Longitude	
				Start	End
Item	Animal Control			37.236387 °	37.236387 °
				-120.734164 °	-120.734164 °
DWR ID	DWR_NA0010_05_f _ 2018_138				
Comment Code					
A1 : Exterminate rodents and backfill and compact or grout burrows.					
Inspector Comment					
Several large rodent holes are located at this location.

View of large rodent holes in landside slope. (Fall 2018)
