## Flood Control Project Maintenance Levee Inspections

### Fall 2021 Levee Maintenance Deficiency Summary Report

#### San Joaquin River Basin

NA0010 Lower San Joaquin Levee District	Overall LMA Rating	Total LMA Miles							
	U	191.27							
Rated Item	Maintenance Deficiency				Enforcement		Design & System Obsolescence		
	M Miles	U Miles	M + 4U Miles	Threshold %	M Miles	U Miles	M Miles	U Miles	
<i>Earthen Levee</i>									
Vegetation	47.00	9.57	85.28	44.59%					
Trim / Thin Trees	0.10		0.10	0.05%					
Encroachments	0.23	0.02	0.31	0.16%	9.29	0.59			
Animal Control	7.67	2.19	16.43	8.59%					
Slope Stability	0.05	0.01	0.09	0.05%					
Erosion / Bank Caving	0.13	0.81	3.37	1.76%					
Crown Surface / Depressions / Rutting	0.01		0.01	0.01%					
Repair Gates	0.02	0.02	0.10	0.05%					
<i>Rivers, Channels &amp; Designated Floodways</i>									
Encroachments					0.01	0.01			
<i>Supplemental</i>									
DWR Erosion Survey	0.12	0.17	0.80	0.42%					
DWR UCIP Field Study					1.29	0.05			
DWR UCIP LMA Responsibility									
<i>LMA Totals:</i>	55.33	12.79	106.49	55.67%	10.59	0.65	0.00	0.00

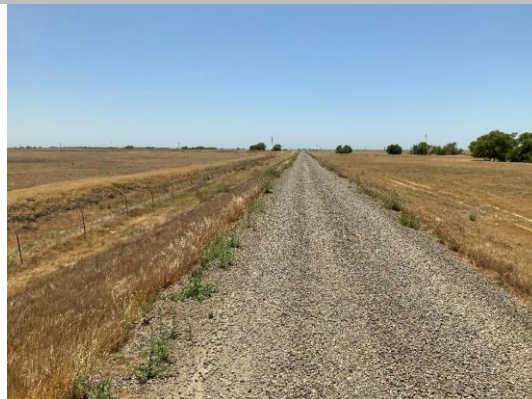
Photo 1 of 3 : UCIP\_FA\_2021\_69874\_100772.jpg

Comment Code					
Inspector Comment					
DS_ID:19775 FS_ID:69874 EP_NO: N/A Repair Type: Non-Urgent EVAL Issue: Limited Inspection/No UCIP Evaluation Crossing Status: Found UCIP Comments: 06/1/2021 The record has been upgraded from No Action Needed to Non-Urgent. LS inlet blocked by barbed wire and was inaccessible, could not inspect. No permit was found authorizing this encroachment. CVFPB will need to review crossing to determine owner. The UCIP inspection was completed with GEI staff, P. Espinoza. (H. Dunn – GEI) FIELD_STRUCT_DESC: 24-inch corrugated metal gravity drainage pipe through the levee, 13 feet below the crown. Flap gate on the waterside (WS) end. Concrete headwall on the landside (LS) end. Concrete U-shaped headwall on the WS end. [Additional Reference(s): DWR Levee Log, 2002 (HLM 6.35), listed as a 24-inch corrugated metal pipe (CMP). USACE San Joaquin O&M Manual, Unit 601 Part 1 (SJR601.1), 1967, Revised 25 May 2011, (HLM 6.35), listed as a 24-inch CMP] FS Date: 6/1/2021

Levee crown looking upstream.

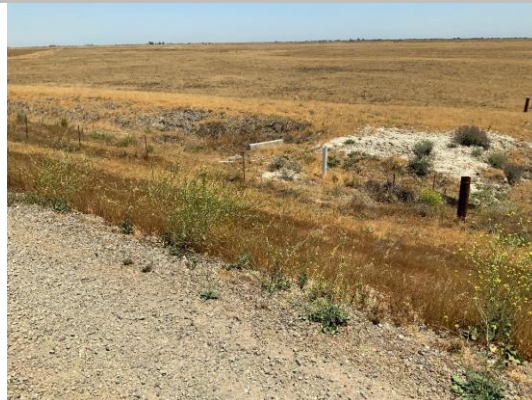
Photo 2 of 3 : UCIP\_FA\_2021\_69874\_100776.jpg

LS view: Toe from crown.

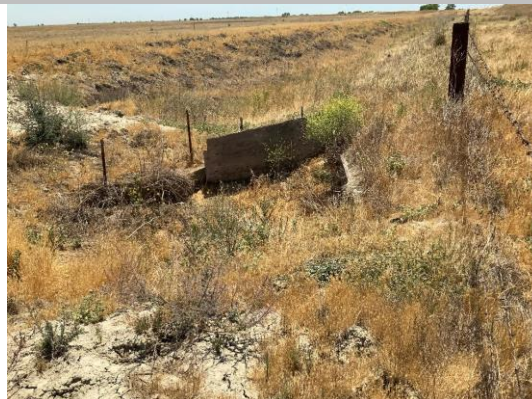
Photo 3 of 3 : UCIP\_FA\_2021\_69874\_100771.jpg

LS view: Headwall visible at toe behind barbed wire.

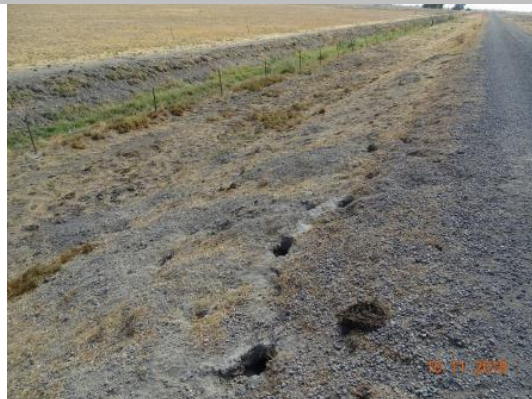
Photo 1 of 1 : FA\_2021\_NA0010\_123\_139\_20210830\_00035.jpg

LM Start	6.40	Rating **	M	Issue No.	139
LM End	6.40	Issue Type +	Ma	Location *	LS
Category	Earthen Levee			GPS Latitude/Longitude	
				Start	End
Item	Animal Control			37.231900 °	37.231900 °
				-120.728345 °	-120.728345 °
DWR ID	DWR_NA0010_05_f_2018_139				
Comment Code					
A1 : Exterminate rodents and backfill and compact or grout burrows.					
Inspector Comment

View of rodent holes on landside shoulder. (Fall 2018)

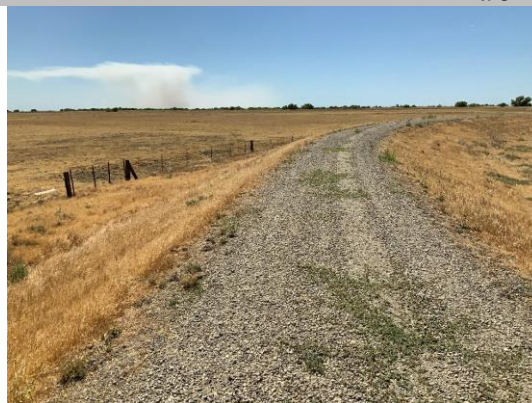
Photo 1 of 3 : UCIP\_FA\_2021\_67754\_100780.jpg

Comment Code					
Inspector Comment					
DS_ID:19761 FS_ID:67754 EP_NO: N/A Repair Type: Non-Urgent EVAL Issue: Maintenance Compliance Issue Crossing Status: Found UCIP Comments: 06/9/2021 The record remains Non-Urgent. Sediment buildup in LS pipe inlet, recommend removal. No permit was found authorizing this encroachment. CVFPB will need to review crossing to determine owner. The UCIP inspection was completed with GEI staff, P. Espinoza. (H. Dunn – GEI) 04/22/2014 Sediment buildup in pipe visible from landward side--recommend contacting owner to clear pipe. (W. Wylie - DWR UCIP) FIELD_STRUCT_DESC: 24-inch corrugated metal gravity drainage pipe through the levee, 12 feet below the crown. Flap gate on the waterside (WS) end. Concrete headwall on the landside (LS) end. Concrete U-shaped headwall on the waterside (WS) end. [Additional Reference(s): DWR Levee Log, 2002 (HLM 7.36), listed as a 24-inch corrugated metal pipe (CMP). USACE San Joaquin O&M Manual, Unit 601 Part 1 (SJR601.1), 1967, Revised 25 May 2011, (HLM 7.36), listed as a 24-inch CMP] FS Date: 6/9/2021

Levee crown looking upstream.

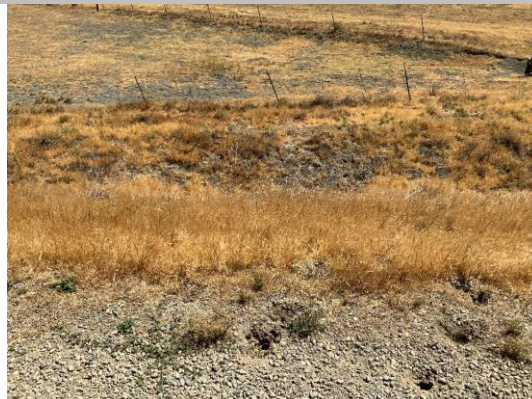
Photo 2 of 3 : UCIP\_FA\_2021\_67754\_100777.jpg

LS view: Toe from crown.

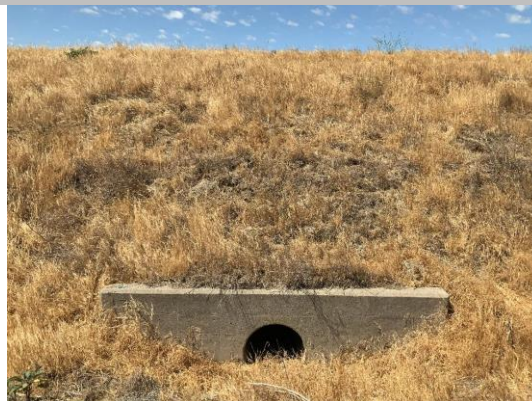
Photo 3 of 3 : UCIP\_FA\_2021\_67754\_100778.jpg

LS view: Slope and headwall at toe.

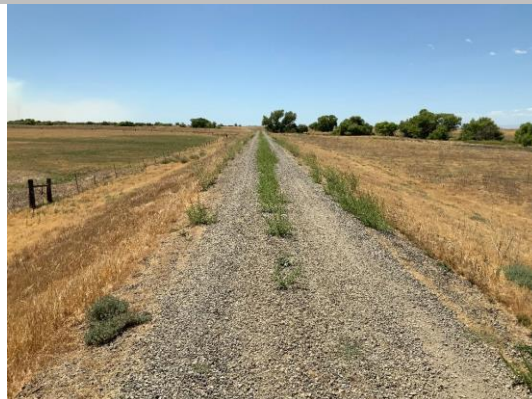
Photo 1 of 3 : UCIP\_FA\_2021\_70180\_100786.jpg

DS\_ID:19762  
FS\_ID:70180  
EP\_NO: N/A  
Repair Type: Non-Urgent  
EVAL Issue: Geophysical Evaluation (Confirmed)  
Crossing Status: Indicator Found  
UCIP Comments: 06/9/2021 The record remains Non-Urgent. No pipe visible on WS or LS during inspection, only indicator found. WS metal riser is bent. DWR DMP Geophysical study indicates possible presence of pipe through levee at (2305907, -13523234), coordinates have been updated. Owner needs to coordinate with the CVFPB to remove or abandon crossing according to Title 23 requirements. No permit was found authorizing this encroachment. CVFPB will need to review crossing to determine owner. The UCIP inspection was completed with GEI staff, P. Espinoza. (H. Dunn – GEI) 04/22/2014 Appears abandoned and if so should be done so properly. Slide gate rusted shut on WS slope. Unable to locate inlet or outlet. (W. Wylie - DWR UCIP)  
FIELD\_STRUCT\_DESC: 24-inch corrugated metal gravity drainage pipe through the levee, 20.4 feet below the crown. Slide gate in 36-inch corrugated metal pipe (CMP) riser on the waterside (WS) slope. Concrete U-shaped headwall on each end. Not found in 2014.

Levee crown looking upstream.

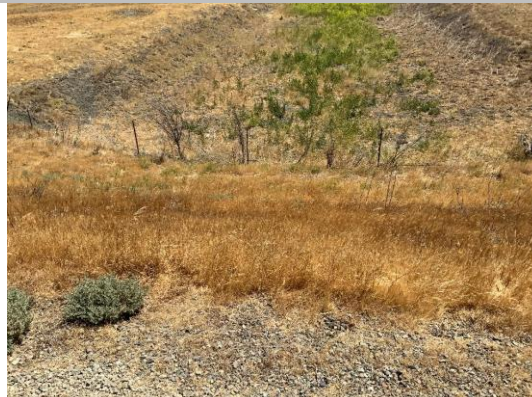
Photo 2 of 3 : UCIP\_FA\_2021\_70180\_100784.jpg

LS view: Toe from crown.

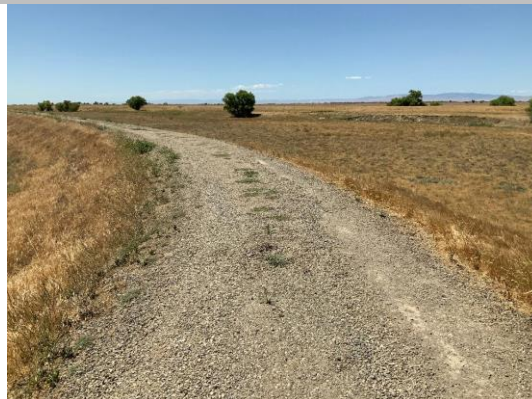
Photo 1 of 3 : UCIP\_FA\_2021\_69876\_100805.jpg

DS\_ID:19844  
FS\_ID:69876  
EP\_NO: N/A  
Repair Type: Non-Urgent  
EVAL Issue: Unauthorized Encroachment, installed decades prior  
Crossing Status: Found  
UCIP Comments: 06/9/2021 The record has been upgraded from No Action Needed to Non-Urgent. DWR DMP internal inspection has not found pipe integrity issues. LOF of crossing is less or equal to 4.0. Recommend next video inspection in 5 years. No permit was found authorizing this encroachment. CVFPB will need to review crossing to determine owner. The UCIP inspection was completed with GEI staff, P. Espinoza. (H. Dunn – GEI) 08/01/2018 USACE O&M manual has pipe listed under Unit 10 HLM 0.02, however, based on the current levee alignment pipe is located under Unit 5 CLM 7.68. Discrepancy in pipe O&M reference is based on reference between Historic Levee Alignment and Current Levee Alignment. (DWR UCIP - O. Magana)  
FIELD\_STRUCT\_DESC: 24-inch corrugated metal gravity drainage pipe through the levee, 9.4 feet below the crown. Flap gate on the waterside (WS) end. Concrete headwall on the landside (LS) end. Concrete U-shaped headwall on the WS end. [Additional Reference(s): DWR Levee Log, 2002. USACE San Joaquin O&M Manual 601.1, 1967, (recorded as Unit 10 HLM 0.02 located in Unit 5 CLM 7.68)].

Levee crown looking upstream.

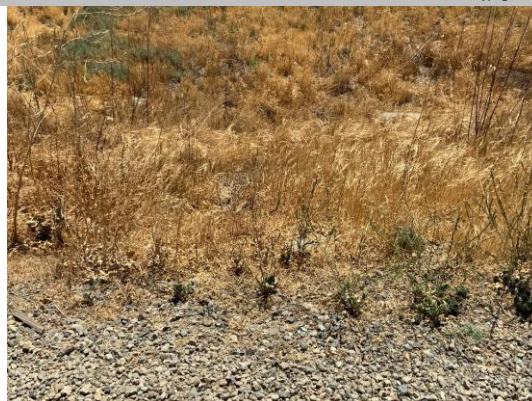
Photo 2 of 3 : UCIP\_FA\_2021\_69876\_100809.jpg

LS view: Toe from crown.

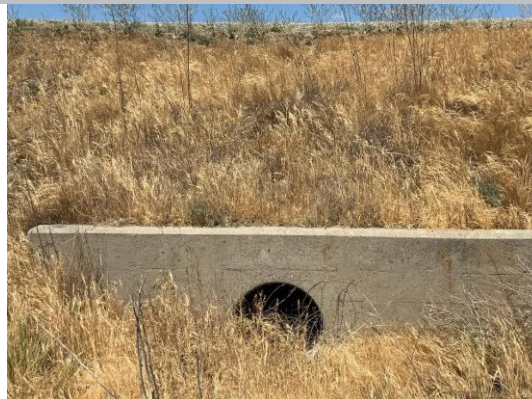
Photo 3 of 3 : UCIP\_FA\_2021\_69876\_100803.jpg

LS view: Slope and headwall at toe.

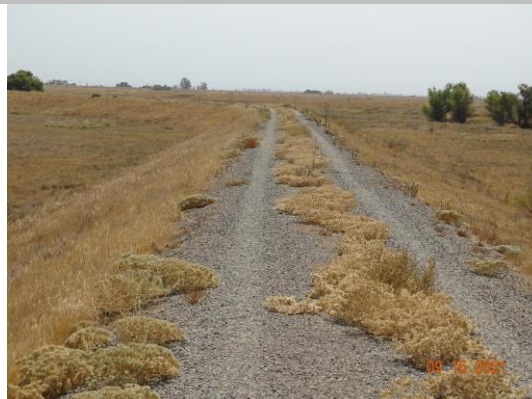
Photo 1 of 1 : FA\_2021\_NA0010\_123\_149\_20210929\_00335.jpg

LM Start	7.73	Rating **	M	Issue No.	149
LM End	8.07	Issue Type +	Ma	Location *	CR
Category	Earthen Levee			GPS Latitude/Longitude	
				Start	End
Item	Vegetation			37.217167 °	37.213709 °
				-120.711161 °	-120.706803 °
DWR ID	DWR_NA0010_05_f_2021_149				
Comment Code					
V9 : Keep the crown roadway free of vegetation.					
Inspector Comment

View of grassy vegetation growing along the levee crown. (Fall 2021)

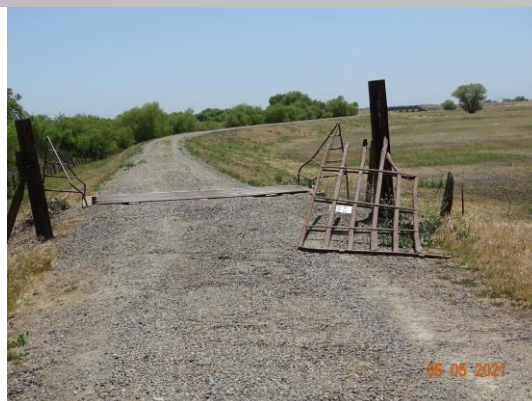
Photo 1 of 1 : FA\_2021\_NA0010\_123\_104\_20210830\_00013.jpg

LM Start	8.09	Rating **	M	Issue No.	104
LM End	8.09	Issue Type +	Ma	Location *	CR
Category	Earthen Levee			GPS Latitude/Longitude	
				Start	End
Item	Repair Gates			37.213580 °	37.213580 °
				-120.706550 °	-120.706550 °
DWR ID	DWR_NA0010_05_s_2017_104				
Comment Code					
Inspector Comment					
The gate has completely broken and should be replaced or removed.

View of gate broken on the waterside shoulder. (Spring 2021)

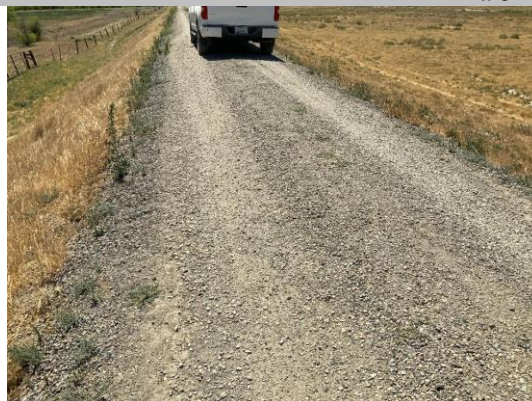
Photo 1 of 3 : UCIP\_FA\_2021\_67759\_100811.jpg

DS\_ID:19763  
FS\_ID:67759  
EP\_NO: N/A  
Repair Type: Non-Urgent  
EVAL Issue: Limited Inspection/No UCIP Evaluation  
Crossing Status: Found  
UCIP Comments: 06/9/2021 The record remains Non-Urgent. Barbed wire over LS pipe inlet, limited inspection due to inaccessibility. No permit was found authorizing this encroachment. CVFPB will need to review crossing to determine owner. The UCIP inspection was completed with GEI staff, P. Espinoza. (H. Dunn – GEI) 04/22/2014 Pipe filled with silt on LS toe and should be cleared. (W. Wylie - DWR UCIP)  
FIELD\_STRUCT\_DESC: 24-inch corrugated metal gravity drainage pipe through the levee, 16 feet below the crown. Flap gate on the waterside (WS) end. Concrete headwall on the landside (LS) end. Concrete U-shaped headwall on the WS end. [Additional Reference(s): DWR Levee Log, 2002 (HLM 8.45), listed as a 24-inch corrugated metal pipe (CMP). USACE San Joaquin O&M Manual, Unit 601 Part 1 (SJR601.1), 1967, Revised 25 May 2011, (HLM 8.44), listed as a 24-inch CMP]

Levee crown looking upstream.

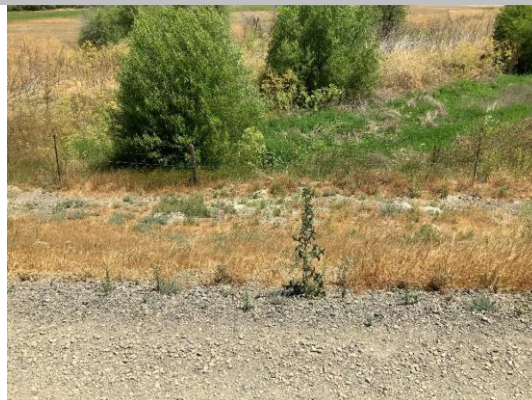
Photo 2 of 3 : UCIP\_FA\_2021\_67759\_100815.jpg

LS view: Toe from crown.

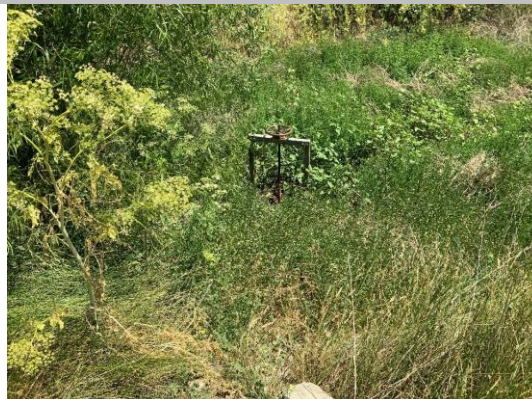
Photo 3 of 3 : UCIP\_FA\_2021\_67759\_100816.jpg

LS view: Slidegate visible at the toe behind barbed wire.

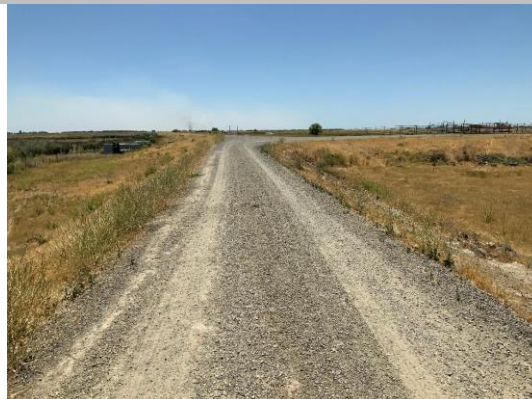
Photo 1 of 3 : UCIP\_FA\_2021\_70115\_100822.jpg

Comment Code						
Inspector Comment						
DS_ID:19764 FS_ID:70115 EP_NO: N/A Repair Type: Non-Urgent EVAL Issue: Limited Inspection/No UCIP Evaluation Crossing Status: Found UCIP Comments: 06/9/2021 The record has been upgraded from No Action Needed to Non-Urgent. Limited inspection of WS and LS due to slidegates and inlets being underwater at the time of inspection. No permit was found authorizing this encroachment. CVFPB will need to review crossing to determine owner. The UCIP inspection was completed with GEI staff, P. Espinoza. (H. Dunn – GEI) 10/27/2017 This structure is inspected annually under the Structure and Channel Summer Inspection (part of the Levee Inspection Program) conducted by the DWR Flood Project Integrity and Inspection Branch (FPIIB). (O. Magana - DWR UCIP) FIELD_STRUCT_DESC: [Deadman Creek Drainage Ditch Structure] 1 of 2: 48-inch by 102-inch reinforced concrete box gravity drainage culvert through the levee, 13.8 feet below the crown. Concrete U-shaped headwall on the waterside (WS) end. Concrete headwall on the landside (LS) end with a slide gate mounted on the headwall. WS slope and outlet drain cobble revetted. [Additional Reference(s): DWR Levee Log, 2002 (HLM 8.83), listed as two 48-inch by 102-inch concrete box culverts referenced as Dead Man Creek Drainage Structure. USACE San Joaquin O&M Manual, Unit 601 Part 1 (SJR601.1), 1967, Revised 25 May 2011, (HLM 8.83), listed as Deadman Creek Drainage Ditch Structure with 2 slide gates] FS Date: 6/9/2021

Levee crown looking upstream.

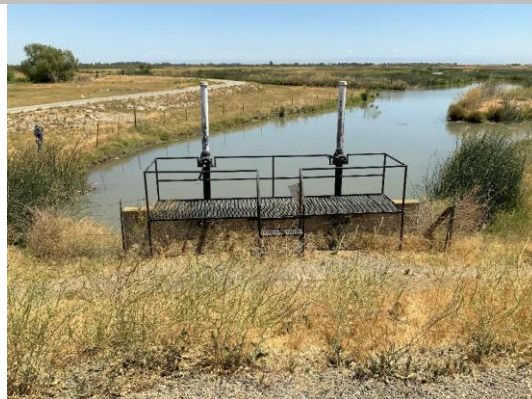
Photo 2 of 3 : UCIP\_FA\_2021\_70115\_100823.jpg

LS view: Slidegates at toe from crown.

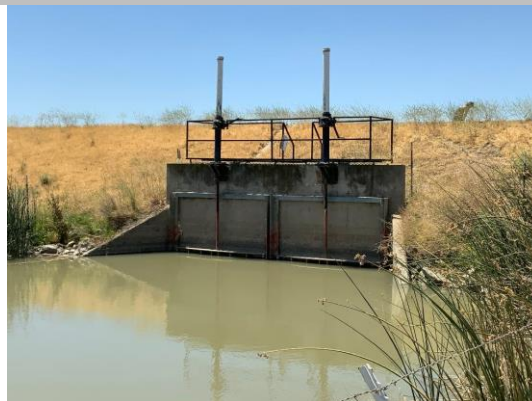
Photo 3 of 3 : UCIP\_FA\_2021\_70115\_100824.jpg

LS view: Slope and slidegates from toe.

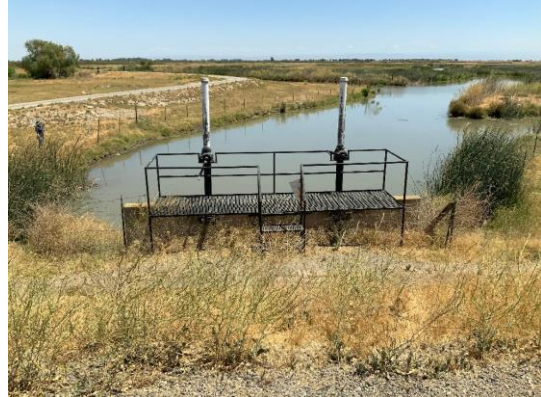
Photo 2 of 3 : UCIP\_FA\_2021\_70116\_100835.jpg

Comment Code						
Inspector Comment						
DS_ID:19735 FS_ID:70116 EP_NO: N/A Repair Type: Non-Urgent EVAL Issue: Limited Inspection/No UCIP Evaluation Crossing Status: Found UCIP Comments: 06/9/2021 The record has been upgraded from No Action Needed to Non-Urgent. Limited inspection of LS and WS due to slidegate and inlet being underwater during inspection. No permit was found authorizing this encroachment. CVFPB will need to review crossing to determine owner. The UCIP inspection was completed with GEI staff, P. Espinoza. (H. Dunn – GEI) 10/27/2017 This structure is inspected annually under the Structure and Channel Summer Inspection (part of the Levee Inspection Program) conducted by the DWR Flood Project Integrity and Inspection Branch (FPIIB). (O. Magana - DWR UCIP) FIELD_STRUCT_DESC: [Deadman Creek Drainage Ditch Structure] 2 of 2: 48-inch by 102-inch reinforced concrete box gravity drainage culvert through the levee, 13.8 feet below the crown. Concrete U-shaped headwall on the waterside (WS) end. Concrete headwall on the landside (LS) end with a slide gate mounted on the headwall. WS slope and outlet drain cobble revetted. [Additional Reference(s): DWR Levee Log, 2002 (HLM 8.83), listed as two 48-inch by 102-inch concrete box culverts referenced as Dead Man Creek Drainage Structure. USACE San Joaquin O&M Manual 601 Part1 (SJR601.1), 1967, Revised 25 May 2011, (HLM 8.83), listed as Deadman Creek Drainage Distch Structure with 2 slide gates]. FS Date: 6/9/2021

LS view: Slidegates visible at toe from crown.

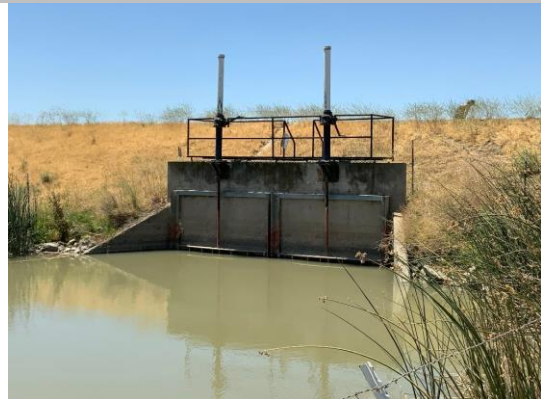
Photo 3 of 3 : UCIP\_FA\_2021\_70116\_100836.jpg

LS view: Slidegates and slope from toe.

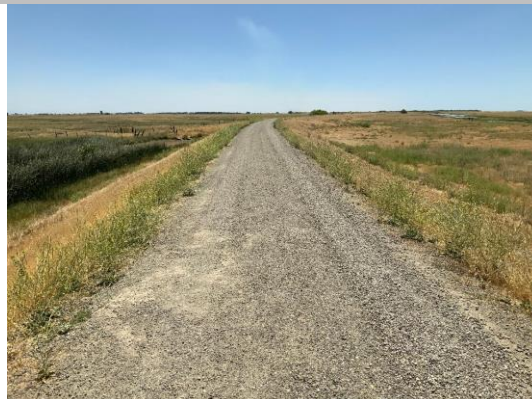
Photo 1 of 3 : UCIP\_FA\_2021\_70121\_100870.jpg

Comment Code						
Inspector Comment						
DS_ID:19766 FS_ID:70121 EP_NO: N/A Repair Type: Non-Urgent EVAL Issue: Safety Issue Crossing Status: Found UCIP Comments: 06/9/2021 The record has been upgraded from No Action Needed to Non-Urgent. LS pipe inlet was underwater during inspection, limited inspection. WS riser is missing half of the cover causing safety hazard. The LS pipe inlet is filled with sediment, recommend removal. No permit was found authorizing this encroachment. CVFPB will need to review crossing to determine owner. The UCIP inspection was completed with GEI staff, P. Espinoza. (H. Dunn – GEI) FIELD_STRUCT_DESC: 36-inch corrugated metal gravity drainage pipe through the levee, 14.8 feet below the crown. Slide gate in a 48-inch corrugated metal pipe (CMP) riser on the waterside (WS) slope. Concrete headwall on each end. [Additional Reference(s): DWR Levee Log, 2002 (HLM 9.24), listed as a 36-inch CMP. USACE San Joaquin O&M Manual, Part 601 Unit 1 (SJR601.1), 1967, Revised 25 May 2011, (HLM 9.26), listed as a 36-inch CMP] FS Date: 6/9/2021

Levee crown looking upstream.

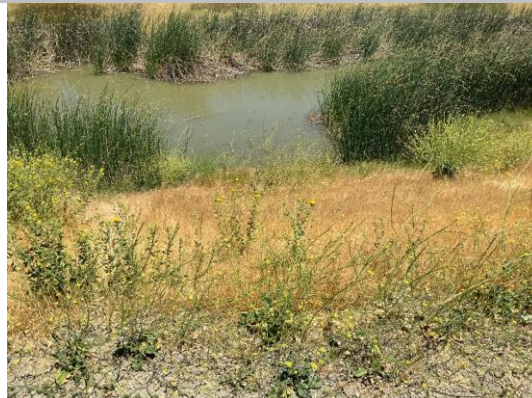
Photo 2 of 3 : UCIP\_FA\_2021\_70121\_100875.jpg

LS view: Toe from crown.

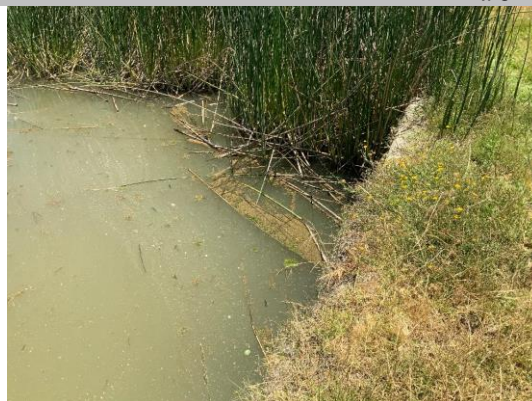
Photo 3 of 3 : UCIP\_FA\_2021\_70121\_100868.jpg

LS view: Headwall visible at toe, pipe is underwater.

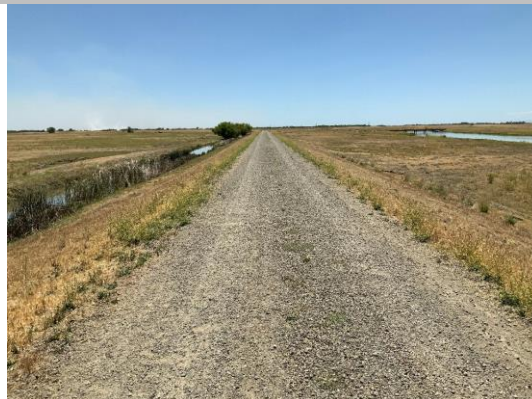
Photo 1 of 3 : UCIP\_FA\_2021\_70122\_100878.jpg

DS\_ID:19767  
FS\_ID:70122  
EP\_NO: N/A  
Repair Type: Non-Urgent  
EVAL Issue: Limited Inspection/No UCIP Evaluation  
Crossing Status: Found  
UCIP Comments: 06/9/2021 The record remains Non-Urgent. LS pipe inlet is underwater, could not inspect. No permit was found authorizing this encroachment. CVFPB will need to review crossing to determine owner. The UCIP inspection was completed with GEI staff, P. Espinoza. (H. Dunn – GEI) 04/22/2014 Slidegate actuator appears bent and may not work properly (WS slope). (W. Wylie - DWR UCIP) FIELD\_STRUCT\_DESC: 24-inch corrugated metal gravity drainage pipe through the levee, 15 feet below the crown. Slide gate in a 36-inch corrugated metal pipe (CMP) riser on the waterside (WS) slope. Concrete headwall on each end. [Additional Reference(s): DWR Levee Log, 2002 (HLM 10.04), listed as a 24-inch corrugated metal pipe (CMP). USACE San Joaquin O&M Manual, Unit 601 Part 1 (SJR601.1), 1967, Revised 25 May 2011, (HLM 10.05), listed as a 24-inch CMP]. FS Date: 6/9/2021

Levee crown looking upstream.

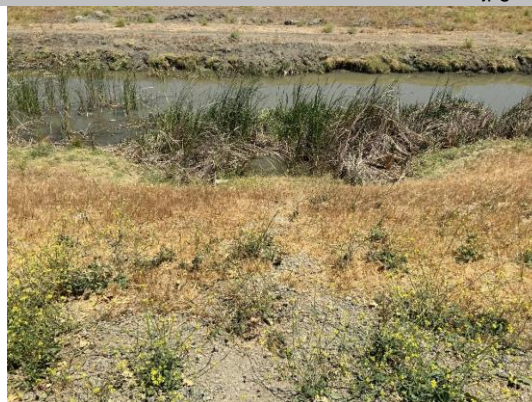
Photo 2 of 3 : UCIP\_FA\_2021\_70122\_100883.jpg

LS view: Toe from crown.

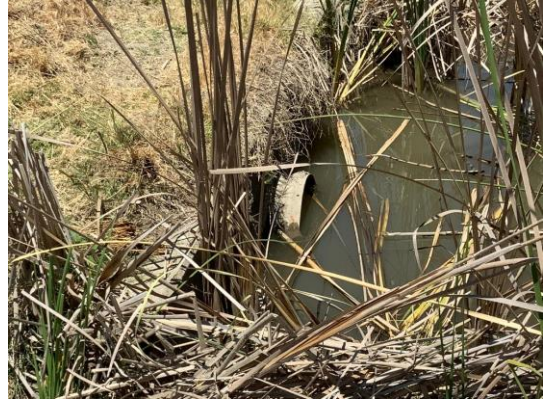
Photo 3 of 3 : UCIP\_FA\_2021\_70122\_100876.jpg

LS view: Closeup of pipe inlet at toe, underwater.

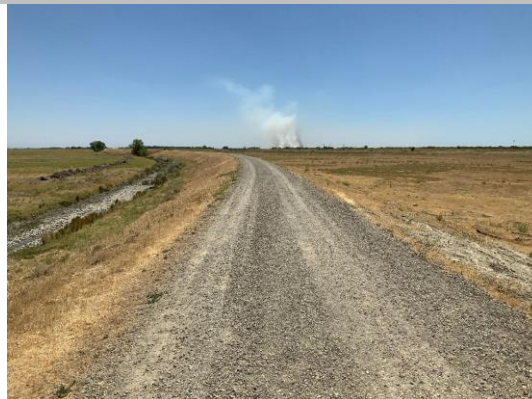
Photo 1 of 3 : UCIP\_FA\_2021\_67782\_100922.jpg

DS\_ID:19737  
 FS\_ID:67782  
 EP\_NO: 18624  
 Repair Type: Non-Urgent  
 EVAL Issue: Limited Inspection/No UCIP Evaluation  
 Crossing Status: Indicator Found  
 UCIP Comments: 06/9/2021 The record has been upgraded from No Action Needed to Non-Urgent. Only indicator found, pipe may be underwater. No pipe visible on LS, only riser. The UCIP inspection was completed with GEI staff, P. Espinoza. (H. Dunn – GEI)  
 FIELD\_STRUCT\_DESC: 36-inch reinforced concrete irrigation pipe through the levee, 20 feet below the crown. Slide gate in a 6-foot-diameter concrete riser on the waterside (WS) shoulder. Concrete inlet structure off the landside (LS) toe. Joints secured in hoop steel and encased in concrete at levee toes. (Permit No. 18624, 2010, [permit not found]).  
 FS Date: 6/9/2021

Levee crown looking upstream.

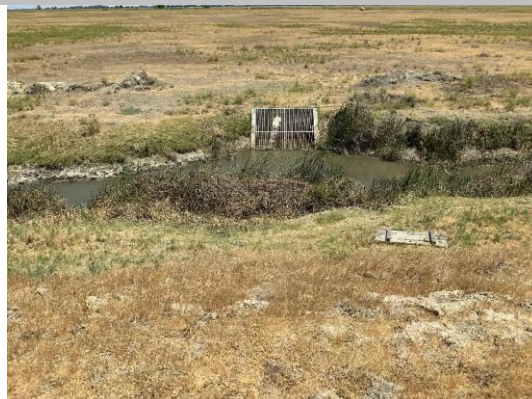
Photo 2 of 3 : UCIP\_FA\_2021\_67782\_100926.jpg

LS view: Toe from crown.

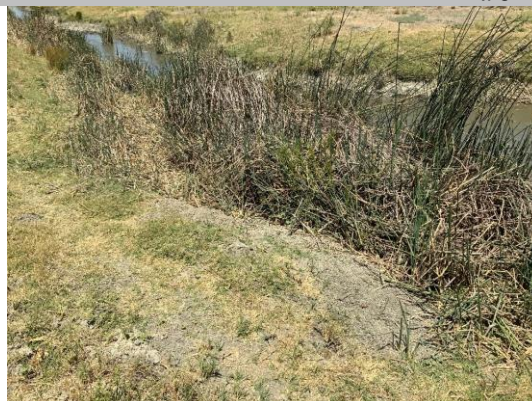
Photo 3 of 3 : UCIP\_FA\_2021\_67782\_100927.jpg

LS view: Dense vegetation at the toe, pipe not visible.

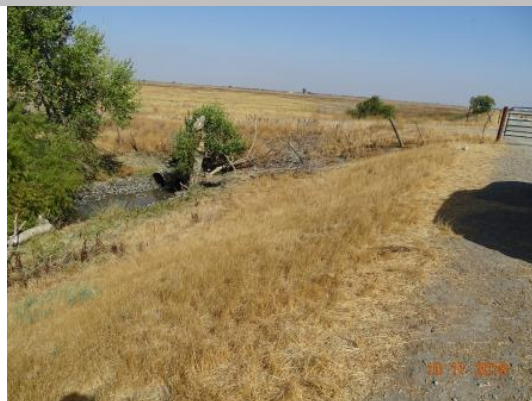
Photo 1 of 1 : FA\_2021\_NA0010\_123\_142\_20210830\_00037.jpg

LM Start	10.66	Rating **	M	Issue No.	142
LM End	10.66	Issue Type +	Ma	Location *	LS
Category	Earthen Levee			GPS Latitude/Longitude	
				Start	End
Item	Encroachments			37.190286 °	37.190286 °
				-120.671207 °	-120.671207 °
DWR ID	DWR_NA0010_05_f _ 2018_142				
Comment Code					
TR : Tree or limb					
Inspector Comment					
A fallen tree is located on the landside toe and slope.

Fallen tree on landside toe and slope. (Fall 2018)

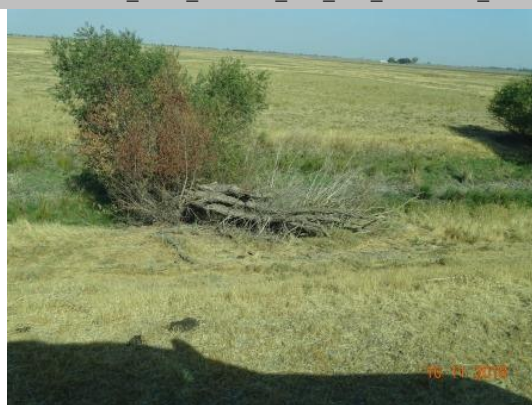
Photo 1 of 1 : FA\_2021\_NA0010\_123\_145\_20210830\_00039.jpg

LM Start	11.41	Rating **	M	Issue No.	145
LM End	11.41	Issue Type +	Ma	Location *	LS
Category	Earthen Levee			GPS Latitude/Longitude	
				Start	End
Item	Trim / Thin Trees			37.187404 °	37.187404 °
				-120.659005 °	-120.659005 °
DWR ID	DWR_NA0010_05_f _ 2018_145				
Comment Code					
T2 : Thin trees to allow visibility of the ground and room to flood fight.					
Inspector Comment					
A fallen tree trunk is located on the levee toe.

Fallen tree on levee toe. (Fall 2018)

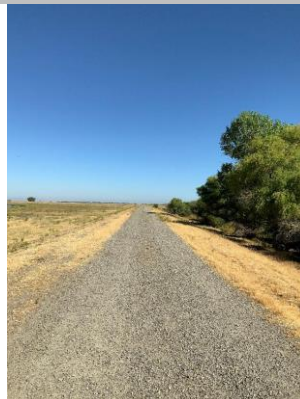
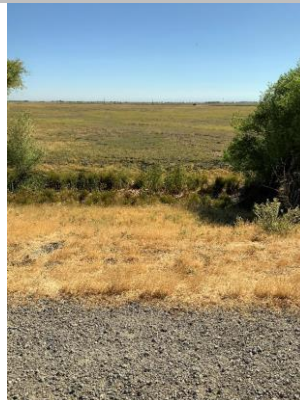
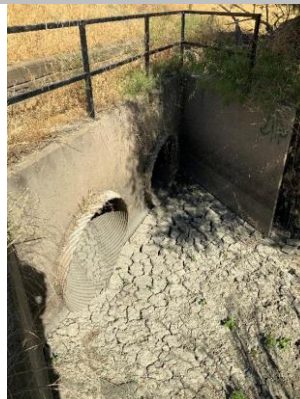
Comment Code					
Inspector Comment					
DS_ID:19768 FS_ID:70181 EP_NO: N/A Repair Type: Non-Urgent EVAL Issue: Unauthorized Encroachment, installed decades prior Crossing Status: Found UCIP Comments: 06/22/2021 The record has been upgraded from No Action Needed to Non-Urgent. Crossing appears to be in good condition. No permit was found authorizing this encroachment. CVFPB will need to review crossing to determine owner. The UCIP inspection was completed with GEI staff, H.Dunn. (P.Espinoza – GEI) FIELD_STRUCT_DESC: [Deadman Drainage Structure] 1 of 2: 48-inch corrugated metal gravity drainage pipe through the levee, 16 feet below the crown. Slide gate in a 60-inch corrugated metal pipe (CMP) riser on the waterside (WS) slope. Concrete U-shaped headwall on each end. Stairs on the landside (LS) slope. [Additional Reference(s): DWR Levee Log, 2002 (HLM 11.45), listed as two 48-inch CMPs referenced as Deadman Drain. USACE San Joaquin O&M Manual, Unit 601 Part 1 (SJR601.1), 1967, Revised 25 May 2011, (HLM 11.48), listed as two 48-inch CMPs] FS Date: 6/22/2021

View from levee crown.

LS view of slope from levee crown.

LS view: concrete headwall and inlet pipe visible on slope.

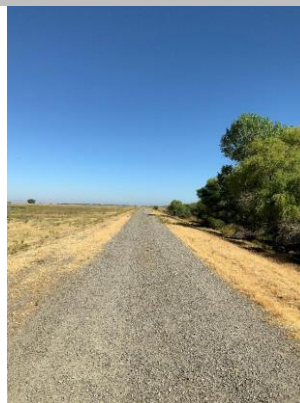
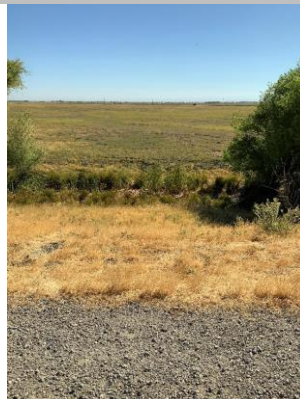
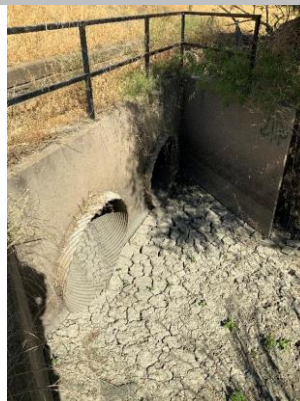
DS\_ID:19734  
 FS\_ID:70167  
 EP\_NO: N/A  
 Repair Type: Non-Urgent  
 EVAL Issue: Unauthorized Encroachment, installed decades prior  
 Crossing Status: Found  
 UCIP Comments: 06/22/2021 The record has been upgraded from No Action Needed to Non-Urgent. Crossing appears to be in good condition. No permit was found authorizing this encroachment. CVFPB will need to review crossing to determine owner. The UCIP inspection was completed with GEI staff, P. Espinoza. (H. Dunn – GEI)  
 FIELD\_STRUCT\_DESC: [Deadman Drainage Structure] 2 of 2: 48-inch corrugated metal gravity drainage pipe through the levee, 16 feet below the crown. Slide gate in a 60-inch corrugated metal pipe (CMP) riser on the waterside (WS) slope. Concrete U-shaped headwall on each end. Stairs on the landside (LS) slope. [Additional Reference(s): DWR Levee Log, 2002 (HLM 11.45), listed as two 48-inch CMPs referenced as Deadman Drain. USACE San Joaquin O&M Manual, Unit 601 Part 1 (SJR601.1), 1967, Revised 25 May 2011, (HLM 11.48), listed as two 48-inch CMPs].

Levee crown.

LS view: Toe from crown.

LS view: Closeup of inlet at toe.

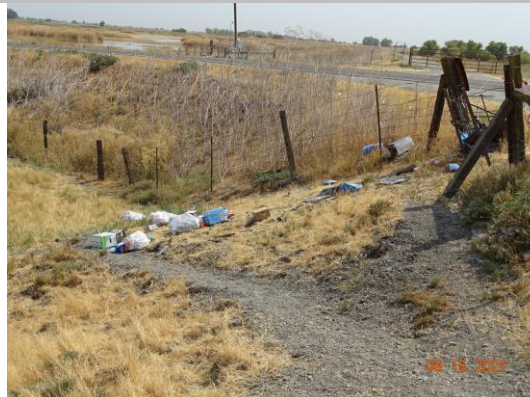
Photo 1 of 1 : FA\_2021\_NA0010\_123\_153\_20210929\_00336.jpg

LM Start	11.51	Rating **	M	Issue No.	153
LM End	11.51	Issue Type +	En	Location *	LS
Category	Earthen Levee			GPS Latitude/Longitude	
				Start	End
Item	Encroachments			37.186302 °	37.186302 °
				-120.657741 °	-120.657741 °
DWR ID	DWR_NA0010_05_f _ 2021_153				
Comment Code					
GA : Garbage					
Inspector Comment

View of garbage dumped on the landside slope and shoulder. (Fall 2021)

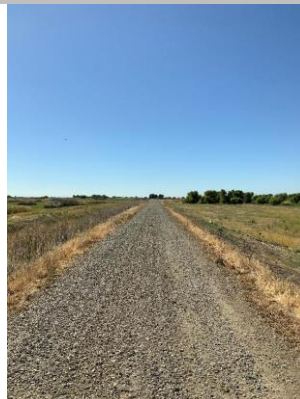
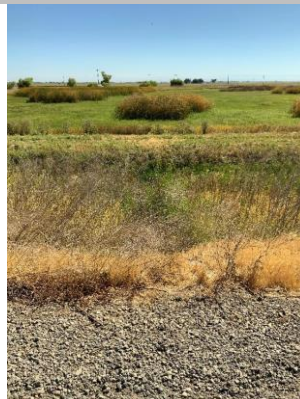
DS\_ID:19704  
FS\_ID:70183  
EP\_NO: N/A  
Repair Type: Urgent  
EVAL Issue: Pipe Integrity  
Crossing Status: Found  
UCIP Comments: 06/22/2021 The record has been upgraded from No Action Needed to Urgent. DWR DMP internal inspection has found pipe integrity issues. LOF of crossing is greater than or equal to 5 and less than 6. Crossing will be monitored until funding becomes available to address the issues. Limited inspection of inlet pipe due to dense vegetation; removal recommended. No permit was found authorizing this encroachment. CVFPB will need to review crossing to determine owner. The UCIP inspection was completed with GEI staff, H.Dunn. (P.Espinoza – GEI)  
FIELD\_STRUCT\_DESC: 24-inch corrugated metal gravity drainage pipe through the levee, 11.8 feet below the crown. Flap gate on the waterside (WS) end. Concrete headwall on the landside (LS) end. Concrete saddle and apron on the WS end. [Additional Reference(s): DWR Levee Log, 2002 (HLM 11.60), listed as a 24-inch corrugated metal pipe (CMP). USACE San Joaquin O&M Manual, Unit 601 Part 1 (SJR601.1), 1967, Revised 25 May 2011, (HLM 11.63), listed as a 24-inch CMP].

View of levee crown.

LS view: slope from crown.

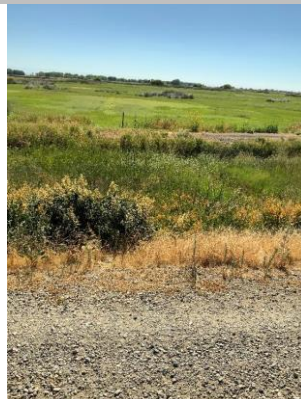
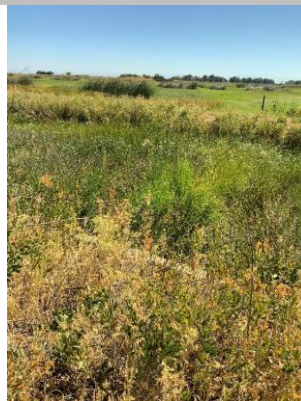
LS view: slope from crown.

LS view: concrete headwall visible at toe.

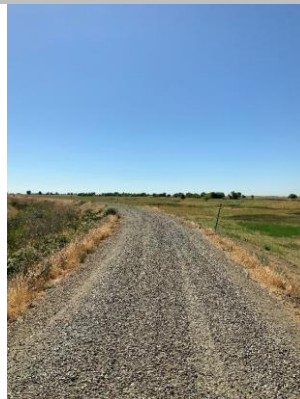
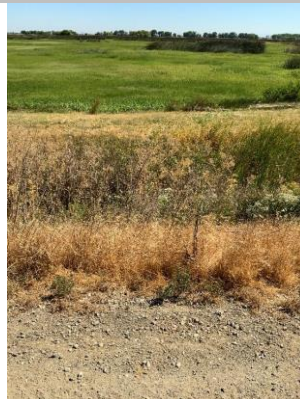
Comment Code						
Inspector Comment						
DS_ID:19706 FS_ID:70198 EP_NO: N/A Repair Type: Urgent EVAL Issue: Pipe Integrity Crossing Status: Found UCIP Comments: 06/22/2021 The record has been upgraded from No Action Needed to Urgent. DWR DMP internal inspection has found pipe integrity issues. LOF of crossing is between 5 and 6. Crossing will be monitored until funding becomes available to address the issues. Erosion around concrete headwall on WS, at least 1 foot in length. Limited inspection of LS due to vegetation and sediment; recommend removal. No permit was found authorizing this encroachment. CVFPB will need to review crossing to determine owner. The UCIP inspection was completed with GEI staff, H.Dunn. (P.Espinoza – GEI) FIELD_STRUCT_DESC: 24-inch corrugated metal gravity drainage pipe through the levee, 10.2 feet below the crown. Flap gate on the waterside (WS) end. Concrete headwall on the landside (LS) end. Concrete saddle and apron on the WS end. Flashboard attachment on the LS end. Pipe crosses levee at 45 degrees to crown alignment. [Additional Reference(s): DWR Levee Log, 2002 (HLM 12.38), listed as a 24-inch corrugated metal pipe (CMP). USACE San Joaquin O&M Manual, Unit 601 Part 1 (SJR601.1), 1967, Revised 25 May 2011, (HLM 12.38), listed as a 24-inch CMP] FS Date: 6/22/2021

View of levee crown.

LS view of slope to toe from crown.

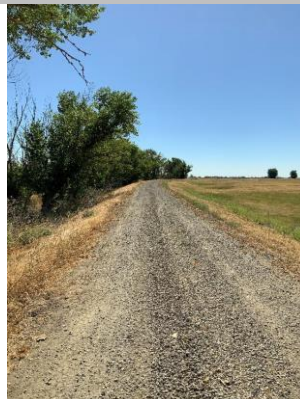
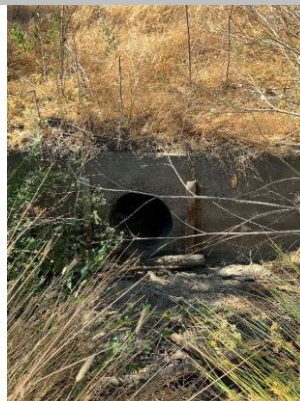
DS\_ID:19707  
FS\_ID:70127  
EP\_NO: N/A  
Repair Type: Non-Urgent  
EVAL Issue: Pipe Damage  
Crossing Status: Found  
UCIP Comments: 06/22/2021 The record remains Non-Urgent. DWR DMP internal inspection has found pipe integrity issues. LOF of crossing is between 4.1 and 5. Crossing will be monitored until funding becomes available for rehabilitation. Limited inspection of LS due to vegetation overgrowth; recommend removal. No permit was found authorizing this encroachment. CVFPB will need to review crossing to determine owner. The UCIP inspection was completed with GEI staff, H.Dunn. (P.Espinoza – GEI) 04/22/2014 Sediment buildup in pipe visible from landward side--recommend contacting owner to clear pipe. (W. Wylie - DWR UCIP)  
FIELD\_STRUCT\_DESC: 24-inch corrugated metal gravity drainage pipe through the levee, 10.2 feet below the crown. Concrete headwall on the landside (LS) end with flashboards. Concrete saddle and apron on the waterside (WS) end with a flap gate. Metal screen at LS toe inlet. [Additional Reference(s): DWR Levee Log, 2002 (HLM 12.87), listed as a 24-inch corrugated metal pipe (CMP). USACE San Joaquin O&M Manual, Unit 601 Part 1 (SJR601.1), 1967, Revised 25 May 2011, (HLM 12.87), listed as a 24-inch CMP]

View of levee crown.

LS view: concrete headwall and inlet pipe at toe.

LS view: concrete headwall and inlet pipe.

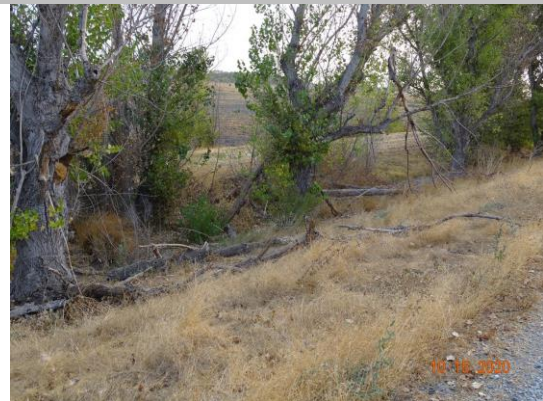
Photo 1 of 1 : FA\_2021\_NA0010\_123\_2\_20210830\_00004.jpg

LM Start	13.01	Rating **	M	Issue No.	2
LM End	13.01	Issue Type +	Ma	Location *	LS
Category	Earthen Levee			GPS Latitude/Longitude	
				Start	End
Item	Encroachments			37.175576 °	37.175576 °
				-120.638755 °	-120.638755 °
DWR ID	DWR_NA0010_05_s_2016_2				
Comment Code					
TR : Tree or limb					
Inspector Comment					
There are several downed trees on landside toe.

Looking west at down tree at landward toe. (Fall 2020)

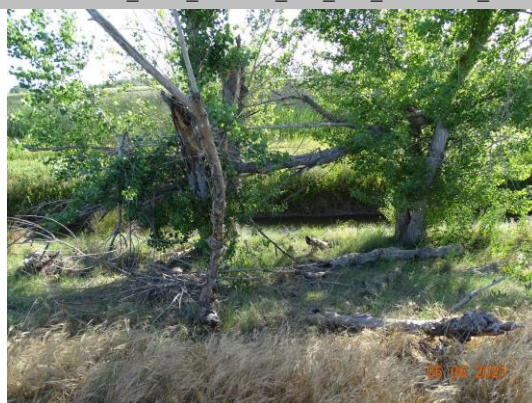
Photo 1 of 1 : FA\_2021\_NA0010\_123\_112\_20210830\_00017.jpg

LM Start	13.37	Rating **	U	Issue No.	112
LM End	13.37	Issue Type +	Ma	Location *	LS
Category	Earthen Levee			GPS Latitude/Longitude	
				Start	End
Item	Encroachments			37.172033 °	37.172033 °
				-120.634005 °	-120.634005 °
DWR ID	DWR_NA0010_05_s_2021_112				
Comment Code					
TR : Tree or limb					
Inspector Comment

View of tree limbs on the landside toe and slope. (Spring 2021)

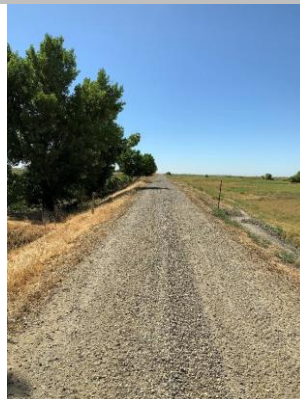
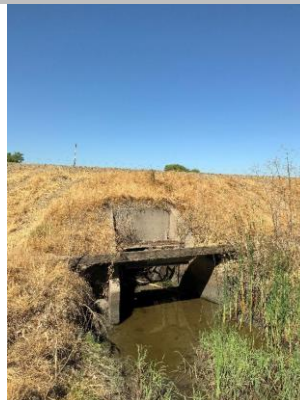
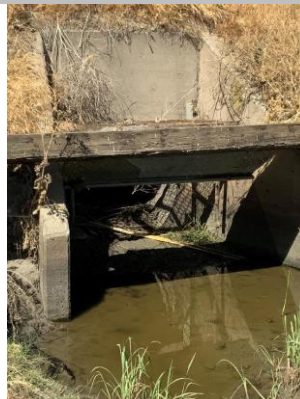
Comment Code						
Inspector Comment						
DS_ID:19708 FS_ID:70128 EP_NO: N/A Repair Type: Non-Urgent EVAL Issue: Limited Inspection/No UCIP Evaluation Crossing Status: Found UCIP Comments: 06/22/2021 The record remains Non-Urgent. Limited inspection of LS due to water around the inlet at the time of survey. LS inlet has sediment buildup, recommend removal. No permit was found authorizing this encroachment. CVFPB will need to review crossing to determine owner. The UCIP inspection was completed with GEI staff, H.Dunn. (P.Espinoza – GEI) 04/22/2014 Some erosion around headwall on the WS toe and there are animal burrows on both slopes. (W. Wylie - DWR UCIP) FIELD_STRUCT_DESC: 48-inch corrugated metal gravity drainage pipe through the levee, 10 feet below the crown. Flap gate on the waterside (WS) end. Flashboard attachment in concrete U-shaped headwall on the landside (LS) end. Concrete U-shaped headwall on the WS end. [Additional Reference(s): DWR Levee Log, 2002 (HLM 13.40), listed as a 48-inch corrugated metal pipe (CMP). USACE San Joaquin O&M Manual, Unit 601 Part 1 (SJR601.1), 1967, Revised 25 May 2011, (HLM 13.40), listed as a 48-inch CMP]. FS Date: 6/22/2021

View of levee crown.

LS view from toe: concrete headwall and inlet pipe. Slope visible in background.

LS view from toe: closeup of concrete headwall and inlet.

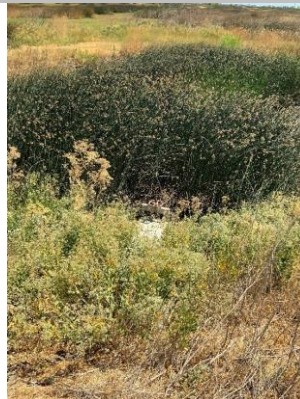
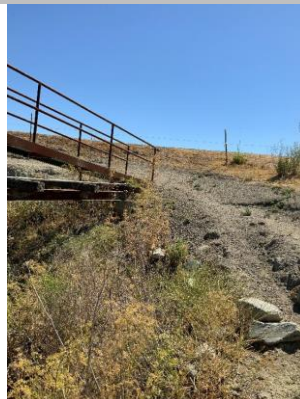
Comment Code					
Inspector Comment					
DS_ID:19709 FS_ID:70129 EP_NO: N/A Repair Type: Non-Urgent EVAL Issue: Pipe Not Found Crossing Status: Indicator Found UCIP Comments: 06/22/2021 The record remains Non-Urgent. Only LS slidegate visible, nothing seen on WS. DWR DMP geophysical study did not confirm presence of pipe through levee. Record will remain in UCIP's inspection records until future Levee Improvement Project can confirm no crossing was found through the levee. No permit was found authorizing this encroachment. CVFPB will need to review crossing to determine owner. The UCIP inspection was completed with GEI staff, H.Dunn. (P.Espinoza – GEI)04/22/2014 Pipe not visible and may need to have silt removed from outlet on WS toe. (W. Wylie - DWR UCIP) FIELD_STRUCT_DESC: 24-inch corrugated metal gravity drainage pipe through the levee, 10 feet below the crown. Flap gate on the waterside (WS) end. Slide gate on concrete headwall at the landside (LS) toe. Concrete saddle and apron on the WS end. [Additional Reference(s): DWR Levee Log, 2002 (HLM 13.70), listed as a 24-inch corrugated metal pipe (CMP). USACE San Joaquin O&M Manual, Unit 601 Part 1 (SJR601.1), 1967, Revised 25 May 2011, (recorded as HLM 14.72 should be 13.72), listed as a 24-inch CMP] FS Date: 6/22/2021

View of levee crown.

LS view of slope to toe from crown.

WS view of slope from toe.

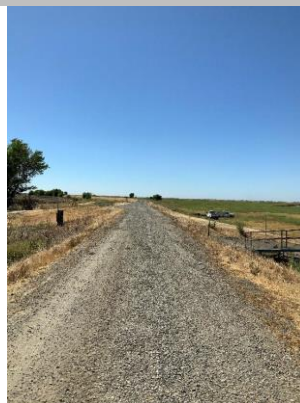
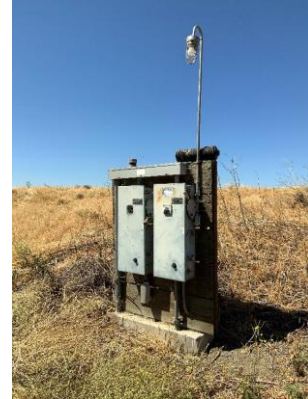
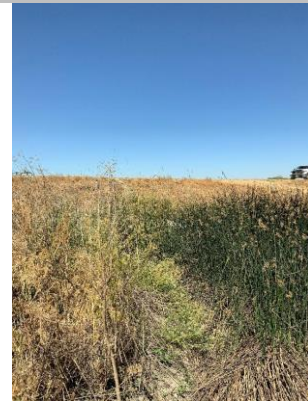
DS\_ID:19566  
 FS\_ID:70130  
 EP\_NO: 17044  
 Repair Type: Non-Urgent  
 EVAL Issue: Limited Inspection/No UCIP Evaluation  
 Crossing Status: Found  
 UCIP Comments: 06/22/2021 The record has been upgraded from No Action Needed to Non-Urgent. Limited inspection of LS slidegate due to dense vegetation, recommend removal. The UCIP inspection was completed with GEI staff, P. Espinoza. (H. Dunn – GEI)  
 FIELD\_STRUCT\_DESC: 20-inch coated steel drainage discharge pipe through the levee, 2 feet below the crown. Pump station off the landside (LS) toe. Siphon breaker on the apex of the pipe on the LS shoulder. Pipe extends past waterside (WS) slope to outlet in channel. Riprap around WS pipe outlet. (Plans to construct two pump stations on the levee, including 24-inch and 20-inch steel discharge pipes through the levee authorized under Permit No. 17044, 1999 - Merced National Wildlife Service/Ducks Unlimited, Inc.).

Levee crown.

LS view: Meters on the toe.

LS view: Slope from toe.

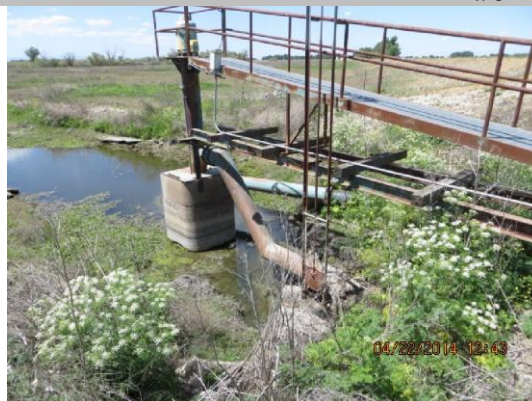
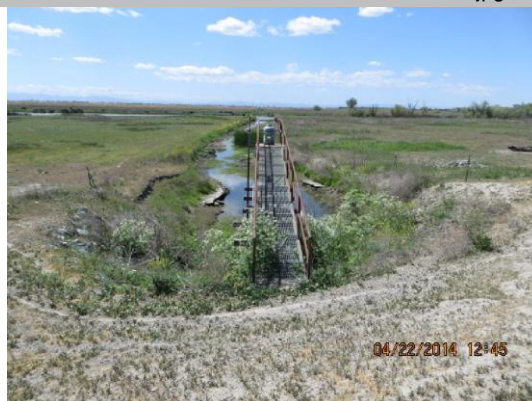
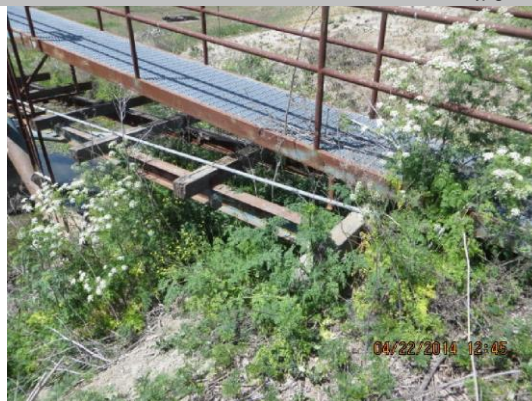
Comment Code						
Inspector Comment						
DS_ID:24869 FS_ID:70131 EP_NO: N/A Repair Type: Non-Urgent EVAL Issue: Unauthorized Encroachment Crossing Status: Found UCIP Comments: 06/23/2021 The record has been upgraded from No Action Needed to Non-Urgent. Crossing appears in good condition. No permit was found authorizing this encroachment. CVFPB will need to review crossing to determine owner. The UCIP inspection was completed with GEI staff, P. Espinoza. (H. Dunn – GEI) FIELD_STRUCT_DESC: 20-inch coated steel irrigation discharge pipe through the levee, at an unknown depth. Pump on metal pile structure on the waterside (WS) toe with walkway. Pipe outlet not found at the landside (LS) toe. 1.5-inch galvanized iron electrical conduit at the same location. This crossing was field discovered. FS Date: 6/22/2021

Pump on pier on WS toe with metal walkway and 1.5-inch electrical conduit.

Pump on pier off WS shoulder.

1.5-inch electrical conduit at side of walkway on WS shoulder.

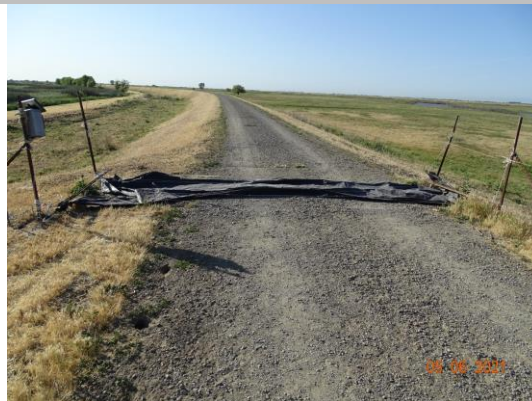
Photo 1 of 1 : FA\_2021\_NA0010\_123\_113\_20210830\_00018.jpg

LM Start	13.76	Rating **	A/W	Issue No.	113
LM End	13.76	Issue Type +	En	Location *	CR
Category	Earthen Levee			GPS Latitude/Longitude	
				Start	End
Item	Encroachments			37.167787 °	37.167787 °
				-120.629480 °	-120.629480 °
DWR ID	DWR_NA0010_05_s_2021_113				
Comment Code					
FE : Fence					
Inspector Comment					
The livestock fence across the crown has been removed, but the setup on the shoulders are still in place.

View of temporary fence installed by landowner. (Spring 2021)

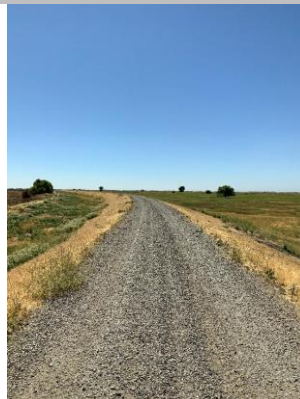
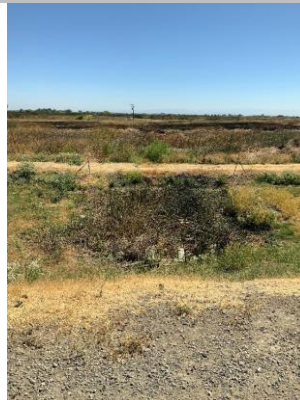
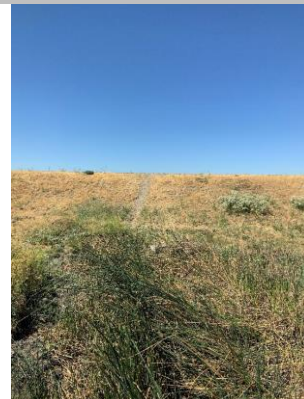
Comment Code					
Inspector Comment					
DS_ID:19710 FS_ID:70199 EP_NO: N/A Repair Type: Urgent EVAL Issue: Levee Integrity Crossing Status: Found UCIP Comments: 06/22/2021 The record has been upgraded from No Action Needed to Urgent. Subsidence along the WS slope that is at least 1 foot in length. Limited inspection of LS due to vegetation; recommend removal. No permit was found authorizing this encroachment. CVFPB will need to review crossing to determine owner. The UCIP inspection was completed with GEI staff, H.Dunn. (P.Espinoza – GEI) FIELD_STRUCT_DESC: 24-inch corrugated metal gravity drainage pipe through the levee, 12.4 feet below the crown. Flap gate on the waterside (WS) end. Concrete headwall on each end. [Additional Reference(s): DWR Levee Log, 2002 (HLM 13.84), listed as a 24-inch corrugated metal pipe (CMP). USACE San Joaquin O&M Manual, Unit 601 Part 1 (SJR601.1), 1967, Revised 25 May 2011, (HLM 13.83), listed as a 24-inch CMP] FS Date: 6/22/2021

View of levee crown.

LS view: slope to toe from crown.

LS view of slope from toe.

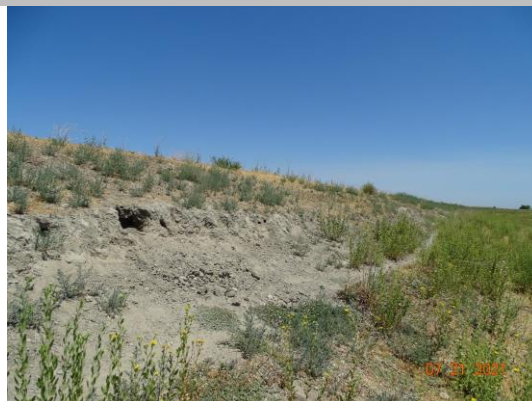
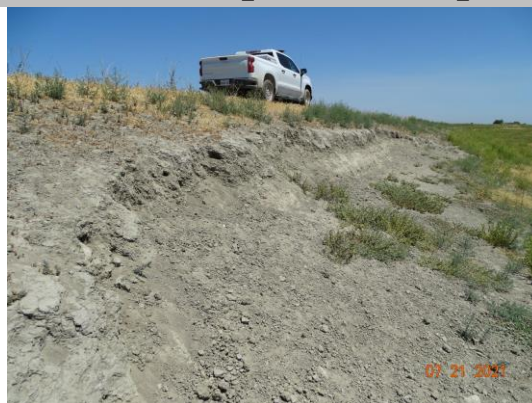
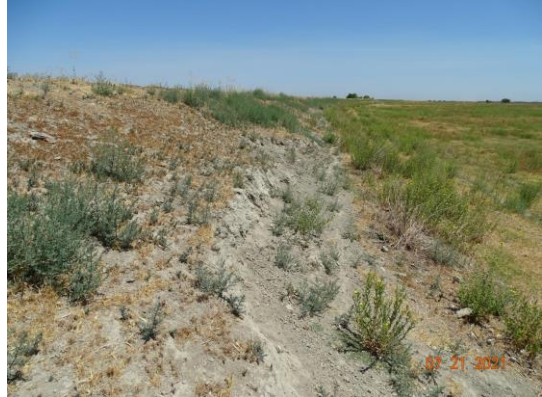
LM Start	14.39	Rating **	M	Issue No.	3
LM End	14.45	Issue Type +	Ma	Location *	
Category	Supplemental			GPS Latitude/Longitude	
				Start	End
Item	DWR Erosion Survey			37.162949 °	37.162949 °
				-120.619138 °	-120.619138 °
DWR ID	NA0010U05RM12.22				
Comment Code					
Inspector Comment					
Site ID: NA0010U05RM12.22					
07/21/2021: This site was discovered during the DWR Spring 2021 Levee Inspections. There is a series of erosion pockets along the lower levee slope and toe, ranging from 3 ft in length to 15 ft and 2 ft to 7 ft in scarp height. There are lots of rodent holes on the entire levee slope.

7/21/2021: View of an erosion pocket and large animal hole looking upstream.

7/21/2021: View of a large erosion pocket.

7/21/2021: Close-up view of the erosion near the upstream end.

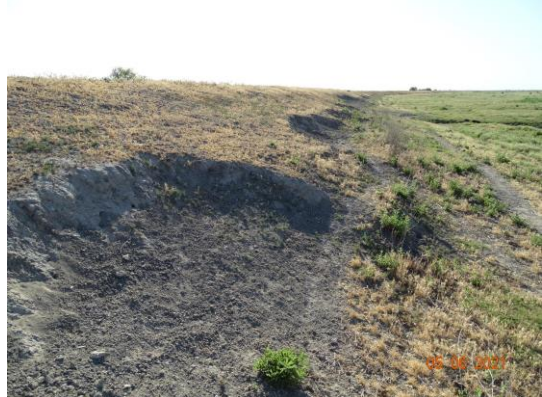
Photo 1 of 1 : FA\_2021\_NA0010\_123\_119\_20210830\_00022.jpg

LM Start	14.42	Rating **	M	Issue No.	119
LM End	14.49	Issue Type +	Ma	Location *	WS
Category	Earthen Levee			GPS Latitude/Longitude	
				Start	End
Item	Erosion / Bank Caving			37.162949 °	37.162540 °
				-120.619138 °	-120.618091 °
DWR ID	DWR_NA0010_05_s_2021_119				
Comment Code					
E1 : Note and monitor erosion site.					
Inspector Comment					
Slope erosion on the waterside slope. Possibly caused by livestock.

Looking upstream along the waterside slope at erosion spots. (Spring 2021)

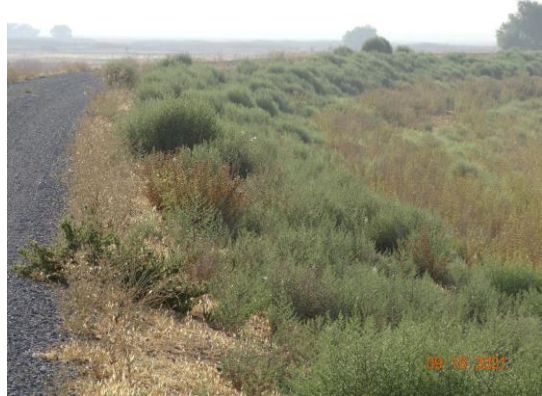
Photo 1 of 1 : FA\_2021\_NA0010\_123\_154\_20210929\_00337.jpg

LM Start	14.45	Rating **	M	Issue No.	154
LM End	15.02	Issue Type +	Ma	Location *	WS
Category	Earthen Levee			GPS Latitude/Longitude	
				Start	End
Item	Vegetation			37.162754 °	37.157601 °
				-120.618661 °	-120.610634 °
DWR ID	DWR_NA0010_05_f_2021_154				
Comment Code					
V1 : Control annual grass and weeds on the levee slopes and easements.					
Inspector Comment

Looking at vegetation along the waterside slope. (Fall 2021)
