## Flood Control Project Maintenance Levee Inspections

### Fall 2021 Levee Maintenance Deficiency Summary Report

#### San Joaquin River Basin

NA0010 Lower San Joaquin Levee District	Overall LMA Rating	Total LMA Miles							
	U	191.27							
Rated Item	Maintenance Deficiency				Enforcement		Design & System Obsolescence		
	M Miles	U Miles	M + 4U Miles	Threshold %	M Miles	U Miles	M Miles	U Miles	
<i>Earthen Levee</i>									
Vegetation	47.00	9.57	85.28	44.59%					
Trim / Thin Trees	0.10		0.10	0.05%					
Encroachments	0.23	0.02	0.31	0.16%	9.29	0.59			
Animal Control	7.67	2.19	16.43	8.59%					
Slope Stability	0.05	0.01	0.09	0.05%					
Erosion / Bank Caving	0.13	0.81	3.37	1.76%					
Crown Surface / Depressions / Rutting	0.01		0.01	0.01%					
Repair Gates	0.02	0.02	0.10	0.05%					
<i>Rivers, Channels &amp; Designated Floodways</i>									
Encroachments					0.01	0.01			
<i>Supplemental</i>									
DWR Erosion Survey	0.12	0.17	0.80	0.42%					
DWR UCIP Field Study					1.29	0.05			
DWR UCIP LMA Responsibility									
<i>LMA Totals:</i>	55.33	12.79	106.49	55.67%	10.59	0.65	0.00	0.00

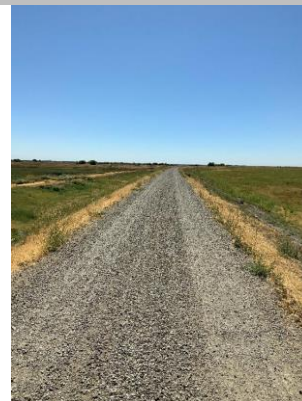
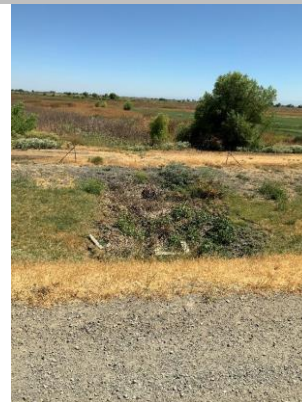
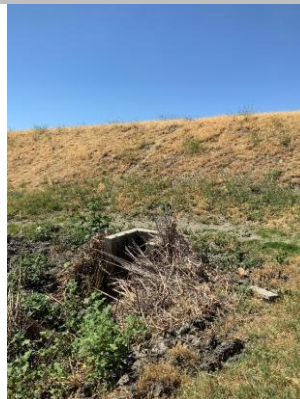
DS\_ID:19711  
FS\_ID:69930  
EP\_NO: N/A  
Repair Type: Non-Urgent  
EVAL Issue: Maintenance Compliance Issue  
Crossing Status: Found  
UCIP Comments: 06/22/2021 The record has been upgraded from No Action Needed to Non-Urgent. Dense vegetation on LS; recommend removal. No permit was found authorizing this encroachment. CVFPB will need to review crossing to determine owner. The UCIP inspection was completed with GEI staff, H.Dunn. (P.Espinoza – GEI)  
FIELD\_STRUCT\_DESC: 24-inch corrugated metal gravity drainage pipe through the levee, 12.5 feet below the crown. Flap gate on the waterside (WS) end. Concrete headwall on each end. Concrete weir inlet structure on the landside (LS) toe. [Additional Reference(s): DWR Levee Log, 2002 (HLM 14.44), listed as a 24-inch corrugated metal pipe (CMP). USACE San Joaquin O&M Manual, Unit 601 Part 1 (SJR601.1), 1967, Revised 25 May 2011, (HLM 14.44), listed as a 24-inch CMP]

View from levee crown.

LS view of slope to toe from crown.

LS view of slope from toe: concrete headwall visible in background.

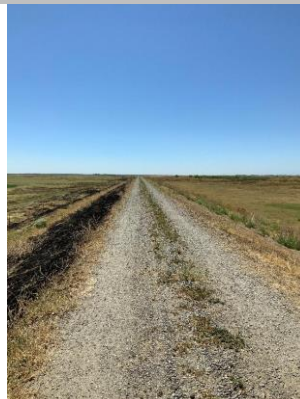
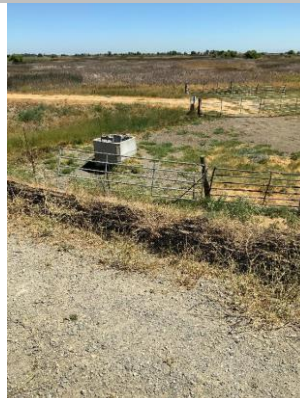
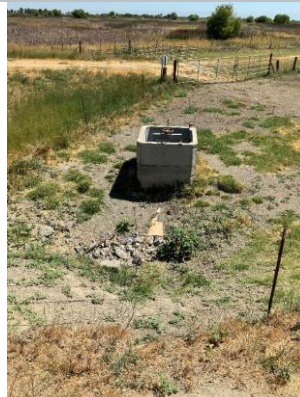
Comment Code					
Inspector Comment					
DS_ID:19712 FS_ID:70187 EP_NO: N/A Repair Type: Non-Urgent EVAL Issue: Levee Damage or Threat for Levee Damage Crossing Status: Found UCIP Comments: 06/22/2021 The record remains Non-Urgent. Limited inspection on LS due to barbed wire and access issues. Build up of sediment at WS outlet pipe and LS inlet pipe; recommend removal. Some erosion along the WS slope, less than 1 foot. No permit was found authorizing this encroachment. CVFPB will need to review crossing to determine owner. The UCIP inspection was completed with GEI staff, H.Dunn. (P.Espinoza – GEI) 04/23/2014 Minor erosion at headwall on WS toe. (W. Wylie - DWR UCIP) FIELD_STRUCT_DESC: 36-inch corrugated metal gravity drainage pipe through the levee, 11.9 feet below the crown. Flap gate on the waterside (WS) end. Concrete headwall on each end. [Additional Reference(s): DWR Levee Log, 2002 (HLM 15.08), listed as a 36-inch corrugated metal pipe (CMP). USACE San Joaquin O&M Manual, Unit 601 Part 1 (SJR601.1), 1967, Revised 25 May 2011, (HLM 15.09), listed as a 36-inch CMP] FS Date: 6/22/2021

View from levee crown.

LS view of slope to toe from crown. Headwall visible in background.

LS view: closeup of headwall and inlet at toe.

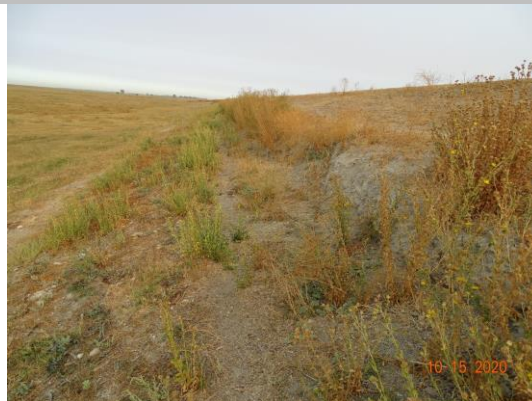
Photo 1 of 1 : FA\_2021\_NA0010\_123\_110\_20210830\_00016.jpg

LM Start	15.21	Rating **	M	Issue No.	110
LM End	15.26	Issue Type +	Ma	Location *	WS
Category	Earthen Levee			GPS Latitude/Longitude	
				Start	End
Item	Erosion / Bank Caving			37.155782 °	37.155337 °
				-120.608075 °	-120.607449 °
DWR ID	DWR_NA0010_05_f_2020_110				
Comment Code					
E1 : Note and monitor erosion site.					
Inspector Comment

Erosion along the waterside slope. (Fall 2020)

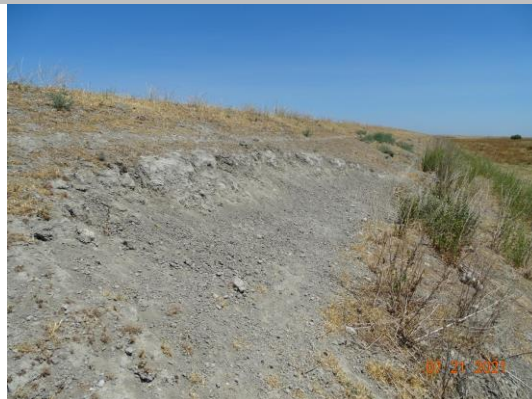
LM Start	15.30	Rating **	M	Issue No.	1	
LM End	15.32	Issue Type +	Ma	Location *		
Category	Supplemental			GPS Latitude/Longitude		
				Start	End	
Item	DWR Erosion Survey			37.154837 °	37.154837 °	
				-120.606737 °	-120.606737 °	
DWR ID	NA0010U05RM13.09					
Comment Code						
Inspector Comment						
Site ID: NA0010U05RM13.09						
07/21/2021: The erosion length was updated to 80 ft based on more accurate field measurements. Otherwise, no significant changes were observed since the previous inspection.						
08/19/2020: This site was discovered during the DWR Spring 2020 Levee Inspections. There is a 20-ft long and an 8-ft long erosion pocket, with scarp heights of up to 3 ft. The erosion has cut into the levee prism. There are signs of rodent and cattle activity.

7/21/2021: View of the erosion looking upstream.

7/21/2021: View of the erosion looking downstream.

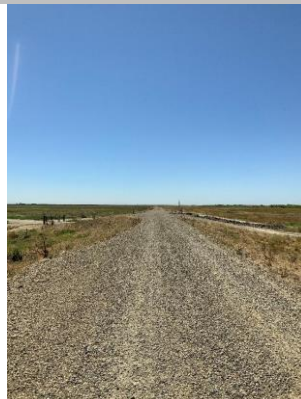
Photo 1 of 3 : UCIP\_FA\_2021\_70133\_104037.jpg

Comment Code					
Inspector Comment					
DS_ID:19713 FS_ID:70133 EP_NO: N/A Repair Type: Non-Urgent EVAL Issue: Unauthorized Encroachment, installed decades prior Crossing Status: Found UCIP Comments: 06/22/2021 The record remains Non-Urgent. Crossing appears to be in good condition. No permit was found authorizing this encroachment. CVFPB will need to review crossing to determine owner. The UCIP inspection was completed with GEI staff, H.Dunn. (P.Espinoza – GEI) 04/23/2014 Sediment buildup in pipe visible from landward side--recommend contacting owner to clear pipe. (W. Wylie - DWR UCIP) FIELD_STRUCT_DESC: 24-inch corrugated metal gravity drainage pipe through the levee, 11 feet below the crown. Flap gate on the waterside (WS) end. Concrete headwall on each end. [Additional Reference(s): DWR Levee Log, 2002 (HLM 15.74), listed as a 24-inch corrugated metal pipe (CMP). USACE San Joaquin O&M Manual, Unit 601 Part 1 (SJR601.1), 1967, Revised 25 May 2011, (HLM 15.74), listed as a 24-inch CMP] FS Date: 6/22/2021

View from levee crown.

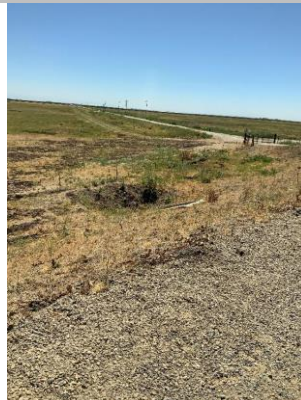
Photo 2 of 3 : UCIP\_FA\_2021\_70133\_104039.jpg

LS view of slope to toe from crown.

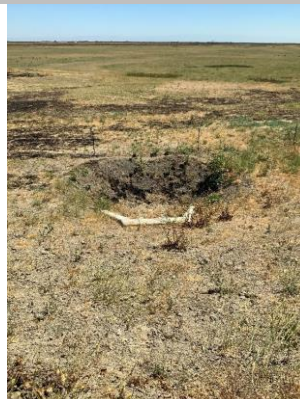
Photo 3 of 3 : UCIP\_FA\_2021\_70133\_104042.jpg

LS view of slope to toe. Concrete headwall visible at toe.

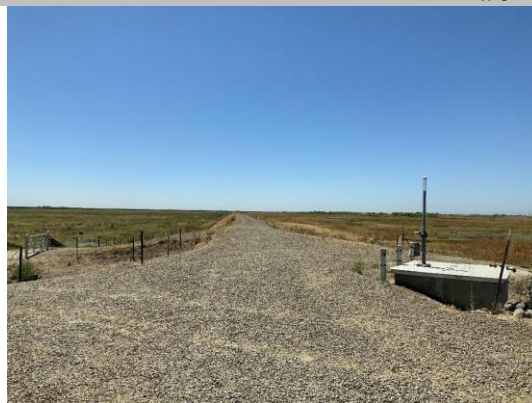
Photo 1 of 3 : UCIP\_FA\_2021\_69932\_104052.jpg

DS\_ID:19714  
 FS\_ID:69932  
 EP\_NO: N/A  
 Repair Type: Non-Urgent  
 EVAL Issue: Limited Inspection/No UCIP Evaluation  
 Crossing Status: Found  
 UCIP Comments: 06/22/2021 The record has been upgraded from No Action Needed to Non-Urgent. Limited inspection of LS and WS due to water present at the time of survey. No permit was found authorizing this encroachment. CVFPB will need to review crossing to determine owner. The UCIP inspection was completed with GEI staff, H.Dunn. (P.Espinoza – GEI)  
 FIELD\_STRUCT\_DESC: 36-inch corrugated metal gravity irrigation pipe through the levee, 9.8 feet below the crown. Slide gate in a 48-inch corrugated metal pipe (CMP) riser on the waterside (WS) slope. Concrete headwall on each end. [Additional Reference(s): DWR Levee Log, 2002 (HLM 15.76), listed as a 36-inch corrugated metal pipe (CMP). USACE San Joaquin O&M Manual, Unit 601 Part 1 (SJR601.1), 1967, Revised 25 May 2011, (HLM 15.77), listed as a 36-inch CMP]

View from levee crown.

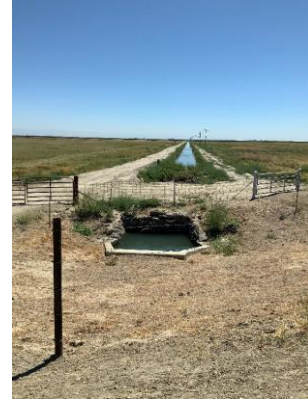
Photo 2 of 3 : UCIP\_FA\_2021\_69932\_104053.jpg

LS view of slope to toe from crown.

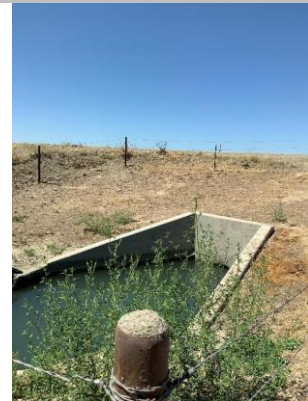
Photo 3 of 3 : UCIP\_FA\_2021\_69932\_104055.jpg

LS view from toe: concrete headwall and inlet pipe. Slope visible in background.

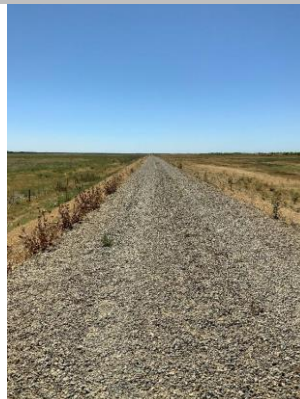
Photo 1 of 3 : UCIP\_FA\_2021\_70134\_104057.jpg

Comment Code						
Inspector Comment						
DS_ID:19715 FS_ID:70134 EP_NO: N/A Repair Type: Non-Urgent EVAL Issue: Unauthorized Encroachment, installed decades prior Crossing Status: Found UCIP Comments: 06/22/2021 The record remains Non-Urgent. Crossing appears to be in good condition. No permit was found authorizing this encroachment. CVFPB will need to review crossing to determine owner. The UCIP inspection was completed with GEI staff, H.Dunn. (P.Espinoza – GEI) 04/23/2014 Excess vegetation at inlet on LS toe should be cleared. (W. Wylie - DWR UCIP) FIELD_STRUCT_DESC: 24-inch corrugated metal gravity drainage pipe through the levee, 12 feet below the crown. Flap gate on the waterside (WS) end. Concrete headwall on the landside (LS) end. Concrete saddle and apron on the WS end. [Additional Reference(s): DWR Levee Log, 2002 (HLM 15.79), listed as a 24-inch corrugated metal pipe (CMP). USACE San Joaquin O&M Manual, Unit 601 Part 1 (SJR601.1), 1967, Revised 25 May 2011, (HLM 15.80), listed as a 24-inch CMP] FS Date: 6/22/2021

View from levee crown.

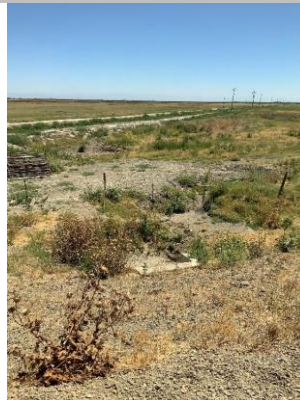
Photo 2 of 3 : UCIP\_FA\_2021\_70134\_104056.jpg

LS view of slope to toe from crown. Concrete headwall visible at toe.

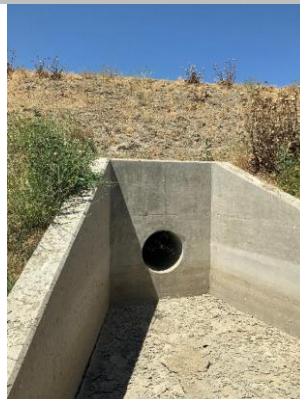
Photo 3 of 3 : UCIP\_FA\_2021\_70134\_104061.jpg

LS view from toe: concrete headwall and inlet. Slope visible in background.

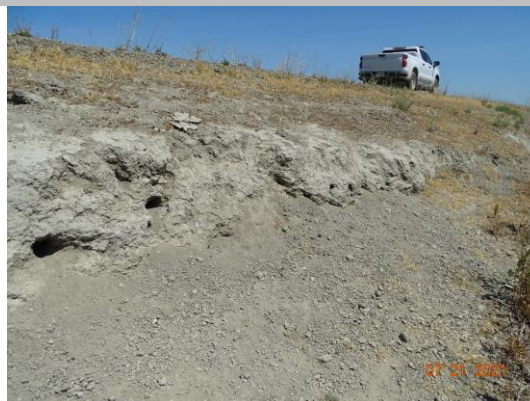
Photo 1 of 2 : SJR2021\_NA0010U05RM13.85\_3.JPG

07/21/2021: From 2020 to present, no significant changes were observed during the annual survey.

08/19/2020: Due to ongoing construction both up and downstream, this site could not be accessed and only be viewed from the opposite bank across the bypass. Unable to determine if the conditions changed since the previous inspection.

09/10/2019: The erosion has become worse during the past 2 flood seasons. The erosion length has increased to approximately 200 ft from 55 ft. Signs of animal activity were observed.

09/20/2017: The erosion was discovered during spring levee inspection. The site is covered by dense vegetation and the measurements of the erosion are estimated.

7/21/2021: View of the erosion and rodent holes.

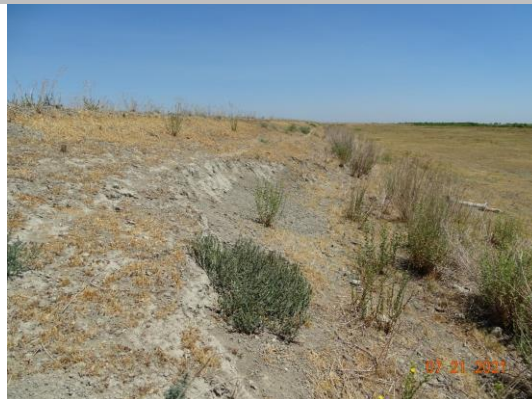
Photo 2 of 2 : SJR2021\_NA0010U05RM13.85\_5.JPG

7/21/2021: View of the erosion looking upstream.

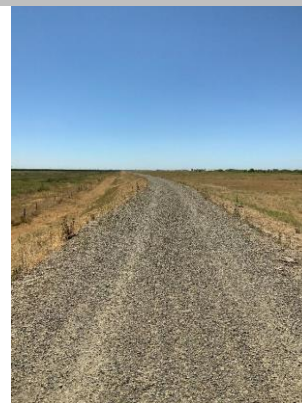
Photo 1 of 3 : UCIP\_FA\_2021\_70135\_104063.jpg

DS\_ID:19716  
 FS\_ID:70135  
 EP\_NO: N/A  
 Repair Type: Non-Urgent  
 EVAL Issue: Unauthorized Encroachment, installed decades prior  
 Crossing Status: Found  
 UCIP Comments: 06/22/2021 The record remains Non-Urgent.  
 Crossing appears to be in good condition. No permit was found authorizing this encroachment. CVFPB will need to review crossing to determine owner. The UCIP inspection was completed with GEI staff, H.Dunn. (P.Espinoza – GEI) 04/23/2014 Pipe heavily silted on LS toe. (W. Wylie - DWR UCIP)  
 FIELD\_STRUCT\_DESC: 24-inch corrugated metal gravity drainage pipe through the levee, 10.5 feet below the crown. Flap gate on the waterside (WS) end. Concrete headwall on each end. [Additional Reference(s): DWR Levee Log, 2002 (HLM 16.66), listed as a 24-inch corrugated metal pipe (CMP). USACE San Joaquin O&M Manual, Unit 601 Part 1 (SJR601.1), 1967, Revised 25 May 2011, (HLM 16.67), listed as a 24-inch CMP]

View from levee crown.

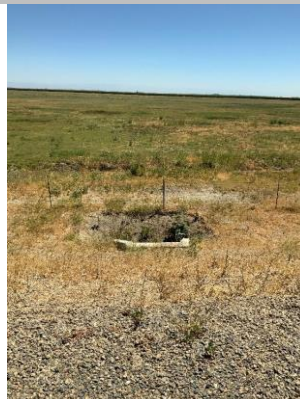
Photo 2 of 3 : UCIP\_FA\_2021\_70135\_104064.jpg

LS view of slope to toe from crown.

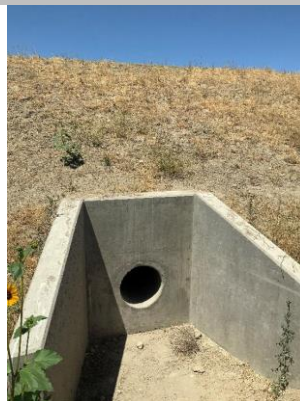
Photo 3 of 3 : UCIP\_FA\_2021\_70135\_104068.jpg

LS view from toe: concrete headwall and inlet. Slope visible in background.

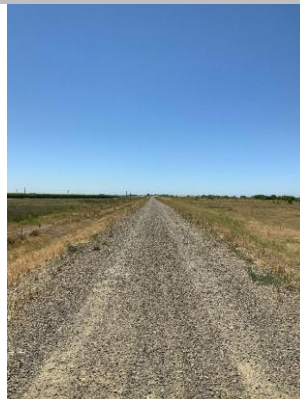
Photo 1 of 3 : UCIP\_FA\_2021\_70136\_104070.jpg

Comment Code					
Inspector Comment					
DS_ID:19717 FS_ID:70136 EP_NO: N/A Repair Type: Non-Urgent EVAL Issue: Unauthorized Encroachment, installed decades prior Crossing Status: Found UCIP Comments: 06/22/2021 The record remains Non-Urgent. Crossing appears to be in good condition. No permit was found authorizing this encroachment. CVFPB will need to review crossing to determine owner. The UCIP inspection was completed with GEI staff, H.Dunn. (P.Espinoza – GEI) 04/23/2014 Sediment buildup in pipe visible from landward side--recommend contacting owner to clear pipe. (W. Wylie - DWR UCIP) FIELD_STRUCT_DESC: 24-inch corrugated metal gravity drainage pipe through the levee, 12 feet below the crown. Flap gate on the waterside (WS) end. Concrete headwall on each end. [Additional Reference(s): DWR Levee Log, 2002 (HLM 17.21), listed as a 24-inch corrugated metal pipe (CMP). USACE San Joaquin O&M Manual, Unit 601 Part 1 (SJR601.1), 1967, Revised 25 May 2011, (HLM 17.20), listed as a 24-inch CMP] FS Date: 6/22/2021

View from levee crown.

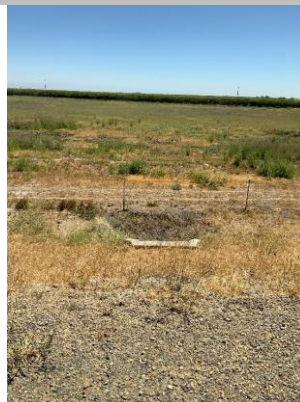
Photo 2 of 3 : UCIP\_FA\_2021\_70136\_104071.jpg

LS view of slope to toe from crown.

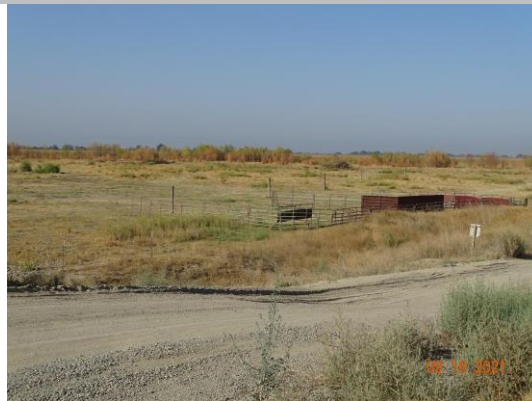
Photo 1 of 1 : FA\_2021\_NA0010\_123\_155\_20210929\_00338.jpg

LM Start	17.54	Rating **	M	Issue No.	155
LM End	17.54	Issue Type +	En	Location *	WS
Category	Rivers, Channels & Designated Floodways			GPS Latitude/Longitude	
				Start	End
Item	Encroachments			37.127871 °	37.127871 °
				-120.585273 °	-120.585273 °
DWR ID	DWR_NA0010_05_f _ 2021_155				
Comment Code					
Inspector Comment					
Livestock pen in the channel.

Landowner has put up a livestock pen within the bypass channel. (Fall 2021)

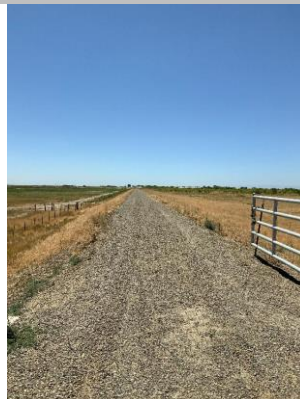
Photo 1 of 3 : UCIP\_FA\_2021\_70137\_104077.jpg

Comment Code					
Inspector Comment					
DS_ID:19743 FS_ID:70137 EP_NO: N/A Repair Type: Non-Urgent EVAL Issue: Unauthorized Encroachment, installed decades prior Crossing Status: Found UCIP Comments: 06/22/2021 The record remains Non-Urgent. Crossing appears to be in good condition. No permit was found authorizing this encroachment. CVFPB will need to review crossing to determine owner. The UCIP inspection was completed with GEI staff, H.Dunn. (P.Espinoza – GEI) 04/23/2014 Sediment buildup in pipe visible from landward side--recommend contacting owner to clear pipe. (W. Wylie - DWR UCIP) FIELD_STRUCT_DESC: 24-inch corrugated metal gravity drainage pipe through the levee, 9.8 feet below the crown. Flap gate on the waterside (WS) end. Concrete headwall on each end. [Additional Reference(s): DWR Levee Log, 2002 (HLM 17.52), listed as a 24-inch corrugated metal pipe (CMP). USACE San Joaquin O&M Manual, Unit 601 Part 1 (SJR601.1), 1967, Revised 25 May 2011, (HLM 17.52), listed as a 24-inch CMP] FS Date: 6/22/2021

View from levee crown.

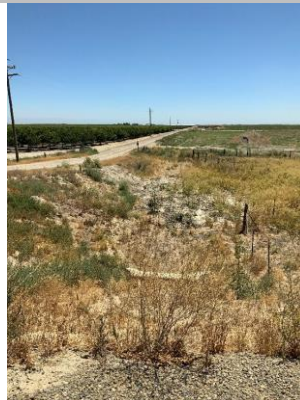
Photo 2 of 3 : UCIP\_FA\_2021\_70137\_104078.jpg

LS view of slope to toe from crown. Concrete headwall visible at toe.

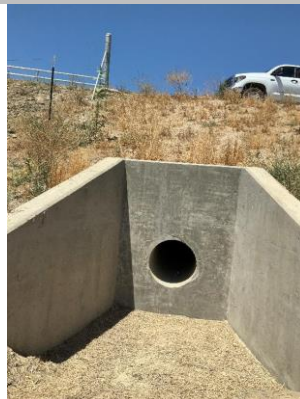
Photo 3 of 3 : UCIP\_FA\_2021\_70137\_104082.jpg

LS view from toe: concrete headwall and inlet. Slope visible in background.

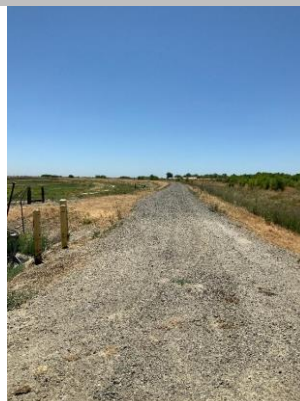
Photo 1 of 3 : UCIP\_FA\_2021\_70138\_104094.jpg

DS\_ID:19744  
 FS\_ID:70138  
 EP\_NO: 3040  
 Repair Type: Non-Urgent  
 EVAL Issue: Limited Inspection/No UCIP Evaluation  
 Crossing Status: Found  
 UCIP Comments: 06/22/2021 The record has been upgraded from No Action Needed to Non-Urgent. Limited inspection of LS outlet due to water flowing through the pipe during time of inspection. Limited inspection of WS inlet due to large herd of cows surrounding inlet. The UCIP inspection was completed with GEI staff, P. Espinoza. (H. Dunn – GEI)  
 FIELD\_STRUCT\_DESC: [Newhall Siphon Crossing] 48-inch corrugated metal irrigation siphon pipe through the levee, 6 feet below the crown. Slide gate in a 60-inch corrugated metal pipe (CMP) riser on the landside (LS) slope. Concrete U-shaped headwall on the LS end. Siphon under channel. 24-inch CMP cleanout at the center of the channel. Metal plate cover. (Plans for construction of two reinforced concrete siphons across the Eastside Bypass authorized under Permit No. 3040, 1959 - Newhall Land and Farming Company).

Levee crown.

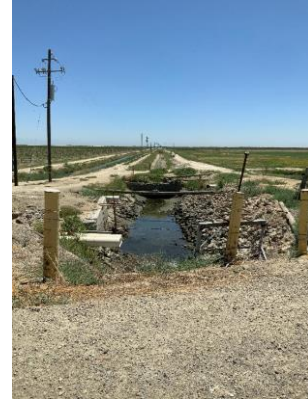
Photo 2 of 3 : UCIP\_FA\_2021\_70138\_104095.jpg

LS view: Toe from crown.

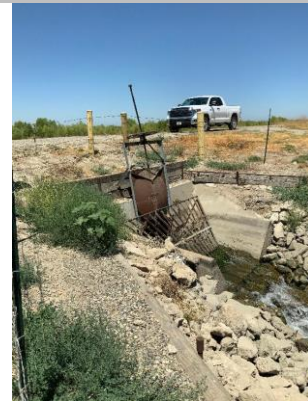
Photo 3 of 3 : UCIP\_FA\_2021\_70138\_104096.jpg

LS view: Slidegate at slope from toe.

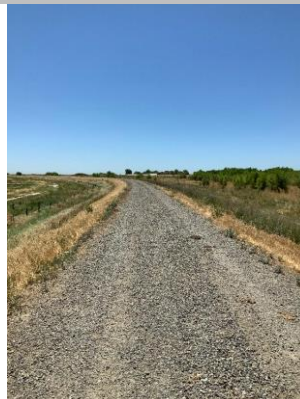
Photo 1 of 3 : UCIP\_FA\_2021\_69969\_104117.jpg

Comment Code						
Inspector Comment						
DS_ID:19745 FS_ID:69969 EP_NO: N/A Repair Type: Non-Urgent EVAL Issue: Limited Inspection/No UCIP Evaluation Crossing Status: Found UCIP Comments: 06/22/2021 The record remains Non-Urgent. Limited inspection of LS pipe inlet due to dense vegetation, recommend removal. No permit was found authorizing this encroachment. CVFPB will need to review crossing to determine owner. The UCIP inspection was completed with GEI staff, P. Espinoza. (H. Dunn – GEI)  04/23/2014 Animal burrows in levee on both slopes. (W. Wylie - DWR UCIP) FIELD_STRUCT_DESC: 24-inch corrugated metal gravity drainage pipe through the levee, 12.4 feet below the crown. Flap gate on the waterside (WS) end. Concrete headwall on each end. [Additional Reference(s): DWR Levee Log, 2002 (HLM 18.07), listed as a 24-inch corrugated metal pipe (CMP). USACE San Joaquin O&M Manual, Unit 601 Part 1 (SJR601.1), 1967, Revised 25 May 2011, (HLM 18.07), listed as a 24-inch CMP] FS Date: 6/22/2021

Levee crown.

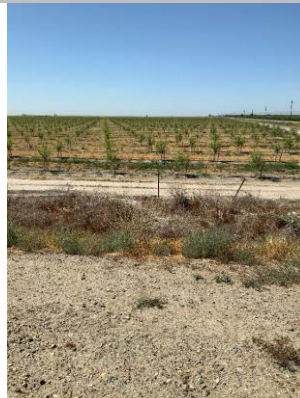
Photo 2 of 3 : UCIP\_FA\_2021\_69969\_104111.jpg

LS view: Toe from crown.

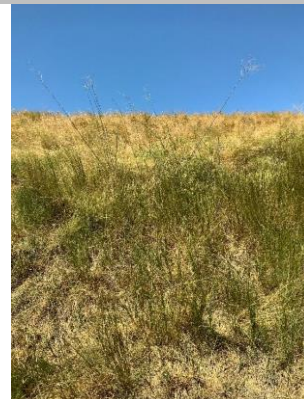
Photo 3 of 3 : UCIP\_FA\_2021\_69969\_104113.jpg

LS view: Slope from toe.

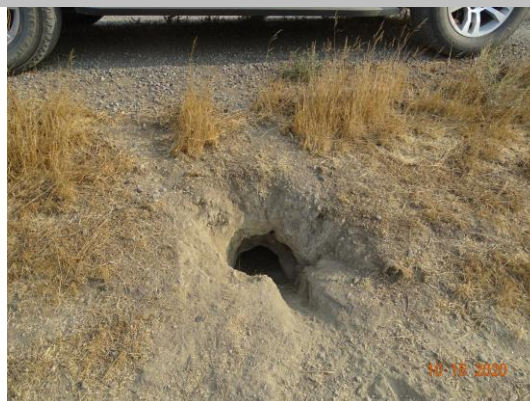
Photo 1 of 1 : FA\_2021\_NA0010\_123\_114\_20210830\_00019.jpg

LM Start	18.50	Rating **	U	Issue No.	114
LM End	18.50	Issue Type +	Ma	Location *	WS
Category	Earthen Levee			GPS Latitude/Longitude	
				Start	End
Item	Animal Control			37.115960 °	37.115960 °
				-120.577170 °	-120.577170 °
DWR ID	DWR_NA0010_05_f_2020_114				
Comment Code					
A3 : No rodents visible, but rodent burrows visible; need to backfill and compact or grout burrows.					
Inspector Comment					
Burrow appears to connect to hole in landside shoulder.

View of rodent burrow in the waterside shoulder. (Fall 2020)

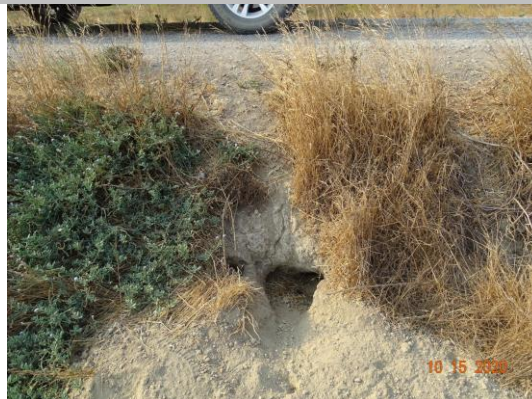
Photo 1 of 1 : FA\_2021\_NA0010\_123\_118\_20210830\_00021.jpg

LM Start	18.50	Rating **	U	Issue No.	118
LM End	18.50	Issue Type +	Ma	Location *	LS
Category	Earthen Levee			GPS Latitude/Longitude	
				Start	End
Item	Animal Control			37.115960 °	37.115960 °
				-120.577170 °	-120.577170 °
DWR ID	DWR_NA0010_05_f_2020_118				
Comment Code					
A3 : No rodents visible, but rodent burrows visible; need to backfill and compact or grout burrows.					
Inspector Comment					
Burrow appears to connect to hole in waterside shoulder.

Large rodent hole in the landside shoulder. (Fall 2020)

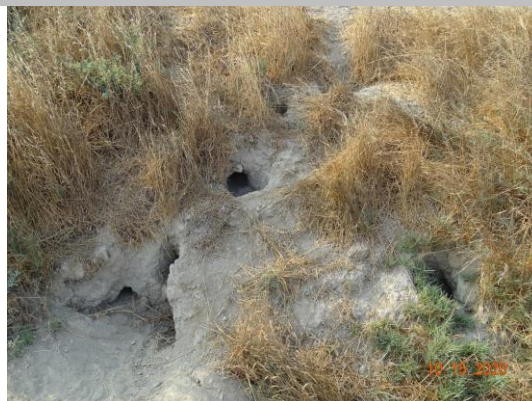
Photo 1 of 1 : FA\_2021\_NA0010\_123\_126\_20210830\_00027.jpg

LM Start	18.62	Rating **	U	Issue No.	126
LM End	18.62	Issue Type +	Ma	Location *	LS
Category	Earthen Levee			GPS Latitude/Longitude	
				Start	End
Item	Animal Control			37.115481 °	37.115481 °
				-120.575126 °	-120.575126 °
DWR ID	DWR_NA0010_05_f_2020_126				
Comment Code					
A3 : No rodents visible, but rodent burrows visible; need to backfill and compact or grout burrows.					
Inspector Comment

Several large rodent holes observed at this location. (Fall 2020)

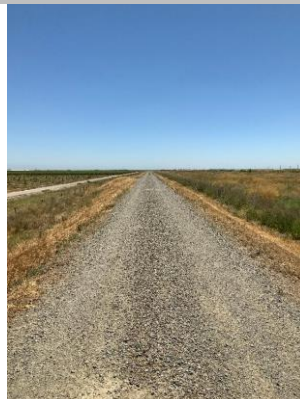
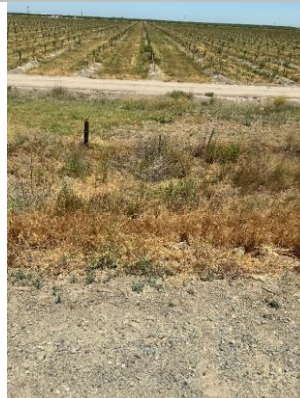
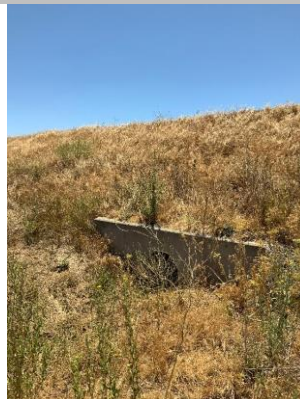
Comment Code					
Inspector Comment					
DS_ID:19746 FS_ID:70139 EP_NO: N/A Repair Type: Non-Urgent EVAL Issue: Unauthorized Encroachment, installed decades prior Crossing Status: Found UCIP Comments: 06/22/2021 The record remains Non-Urgent. Crossing appears to be in good condition. No permit was found authorizing this encroachment. CVFPB will need to review crossing to determine owner. The UCIP inspection was completed with GEI staff, P. Espinoza. (H. Dunn – GEI) 04/23/2014 Dense vegetation limits the inspector's visibility to identify signs of pipe failure (leaks) along the landward slope. Recommend removing vegetation along pipe alignment to conduct proper inspection of structure. (W. Wylie - DWR UCIP) FIELD_STRUCT_DESC: 24-inch corrugated metal gravity drainage pipe through the levee, 10 feet below the crown. Flap gate on the waterside (WS) end. Concrete headwall on the landside (LS) end. Concrete U-shaped headwall on the WS end. [Additional Reference(s): DWR Levee Log, 2002 (HLM 18.68), listed as a 24-inch corrugated metal pipe (CMP). USACE San Joaquin O&M Manual, Unit 601 Part 1 (SJR601.1), 1967, Revised 25 May 2011, (HLM 18.68), listed as a 24-inch CMP] FS Date: 6/22/2021

Levee crown.

LS view: Toe from crown.

LS view: Slope and headwall from toe.

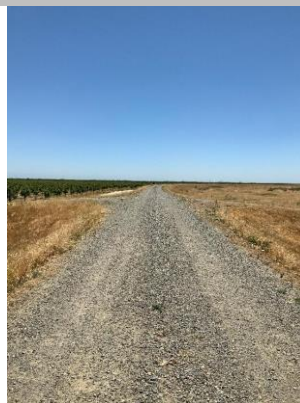
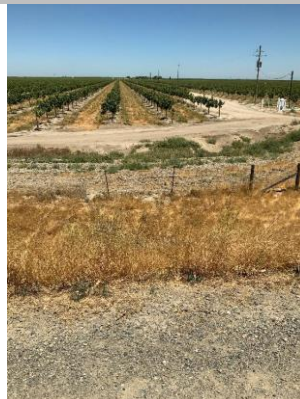
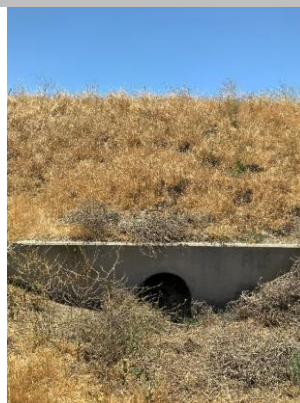
LM Start	<b>19.15</b>	Rating **	M	Issue No.	<b>1358</b>
LM End	<b>19.15</b>	Issue Type +	Ma	Location *	
Category	Supplemental		GPS Latitude/Longitude		
			Start	End	
Item	DWR UCIP LMA Responsibility		37.115466 °	37.115466 °	
			-120.565467 °	-120.565467 °	
DWR ID	19747

DS\_ID:19747  
 FS\_ID:69971  
 EP\_NO: N/A  
 Repair Type: Non-Urgent  
 EVAL Issue: Limited Inspection/No UCIP Evaluation  
 Crossing Status: Found  
 UCIP Comments: 06/22/2021 The record remains Non-Urgent. Limited inspection due to LS inlet being covered by dense tumbleweeds, recommend removal. No permit was found authorizing this encroachment. CVFPB will need to review crossing to determine owner. The UCIP inspection was completed with GEI staff, P. Espinoza. (H. Dunn – GEI) 04/23/2014 Sediment buildup in pipe visible from landward side--recommend contacting owner to clear pipe. (W. Wylie - DWR UCIP)  
 FIELD\_STRUCT\_DESC: 24-inch corrugated metal gravity drainage pipe through the levee, 10 feet below the crown. Flap gate on the waterside (WS) end. Concrete headwall on the landside (LS) end. Concrete U-shaped headwall on the WS end. [Additional Reference(s): DWR Levee Log, 2002 (HLM 19.13), listed as a 24-inch corrugated metal pipe (CMP). USACE San Joaquin O&M Manual, Unit 601 Part 1 (SJR601.1), 1967, Revised 25 May 2011, (HLM 19.11), listed as a 24-inch CMP]

Levee crown.

LS view: Toe from crown.

LS view: Slope and headwall at toe.

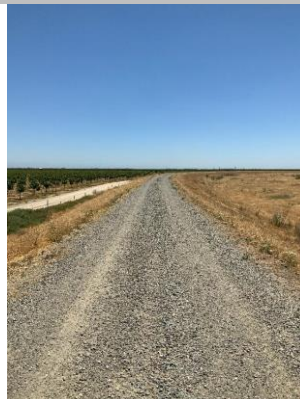
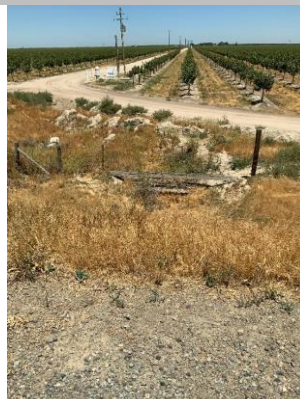
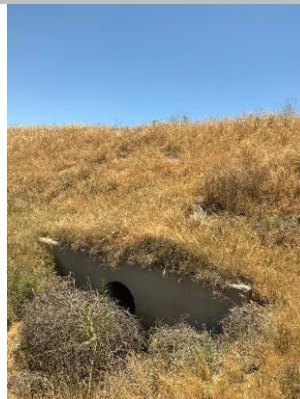
Comment Code						
Inspector Comment						
DS_ID:19776 FS_ID:69972 EP_NO: N/A Repair Type: Non-Urgent EVAL Issue: Maintenance Compliance Issue Crossing Status: Found UCIP Comments: 06/22/2021 The record has been upgraded from No Action Needed to Non-Urgent. Some tumbleweed buildup around LS inlet, recommend removal. No permit was found authorizing this encroachment. CVFPB will need to review crossing to determine owner. The UCIP inspection was completed with GEI staff, P. Espinoza. (H. Dunn – GEI) FIELD_STRUCT_DESC: 24-inch corrugated metal gravity drainage pipe through the levee, 10.3 feet below the crown. Flap gate on the waterside (WS) end. Concrete headwall on the landside (LS) end. Concrete U-shaped headwall on the WS end. [Additional Reference(s): DWR Levee Log, 2002 (HLM 19.15), listed as a 24-inch corrugated metal pipe (CMP). USACE San Joaquin O&M Manual, Unit 601 Part 1 (SJR601.1), 1967, Revised 25 May 2011, (HLM 19.15), listed as a 24-inch CMP] FS Date: 6/22/2021

Levee crown.

LS view: Toe from crown.

LS view: Headwall and slope from toe.

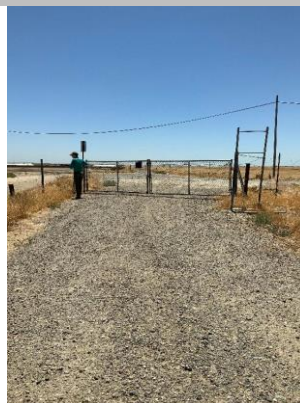
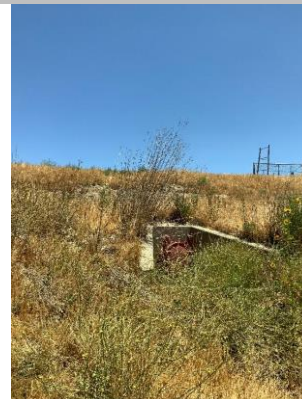
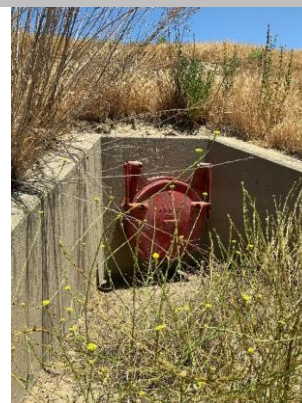
LM Start	<b>19.48</b>	Rating **	U	Issue No.	<b>1360</b>
LM End	<b>19.48</b>	Issue Type +	Ma	Location *	
Category	Supplemental		GPS Latitude/Longitude		
			Start	End	
Item	DWR UCIP LMA Responsibility		37.113542 °	37.113542 °	
			-120.560389 °	-120.560389 °	
DWR ID	19777

DS\_ID:19777  
 FS\_ID:70052  
 EP\_NO: N/A  
 Repair Type: Urgent  
 EVAL Issue: Pipe Integrity  
 Crossing Status: Found  
 UCIP Comments: 06/22/2021 The record has been upgraded from Non-Urgent to Urgent. DWR DMP internal inspection has found pipe integrity issues. LOF of crossing is greater than or equal to 5 and less than 6. Crossing will be monitored until funding becomes available to address the issues. Limited inspection of LS inlet due to vegetation, recommend removal. No permit was found authorizing this encroachment. CVFPB will need to review crossing to determine owner. The UCIP inspection was completed with GEI staff, P. Espinoza. (H. Dunn – GEI)04/23/2014 Sediment buildup in pipe visible from landward side-- recommend contacting owner to clear pipe. (W. Wylie - DWR UCIP)  
 FIELD\_STRUCT\_DESC: 24-inch corrugated metal gravity drainage pipe through the levee, 9 feet below the crown. Flap gate on the waterside (WS) end. Concrete headwall on the landside (LS) end. Concrete U-shaped headwall on the WS end. [Additional Reference(s): DWR Levee Log, 2002 (HLM 19.46), listed as a 24-inch corrugated metal pipe (CMP). USACE San Joaquin O&M Manual, Unit 601 Part 1 (SJR601.1), 1967, Revised 25 May 2011, (HLM 19.46), listed as a 24-inch CMP]

Levee crown.

WS view: Headwall and slope from toe.

WS view: Closeup of flapgate at toe.

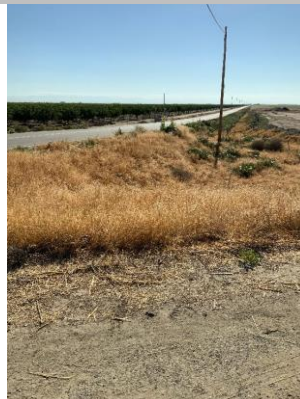
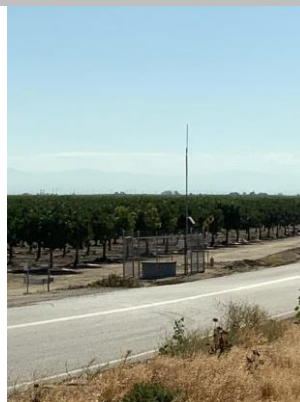
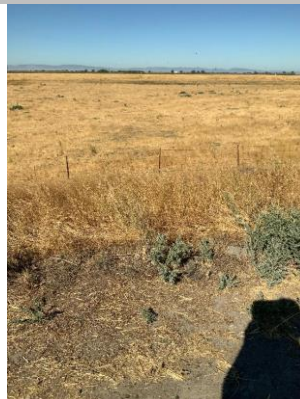
Comment Code						
Inspector Comment						
DS_ID:24868 FS_ID:70140 EP_NO: N/A Repair Type: Non-Urgent EVAL Issue: Safety Issue Crossing Status: Indicator Found UCIP Comments: 06/23/2021 The record remains Non-Urgent. As a safety measure, need to coordinate with owner to determine status of line and to obtain maintenance and inspection records to confirm integrity of line through the levee. No markers or signs visible on LS or WS, recommend putting up signage. No permit was found authorizing this encroachment. CVFPB will need to review crossing to determine owner. The UCIP inspection was completed with GEI staff, P. Espinoza. (H. Dunn – GEI) 04/23/2014 Markers closer to the levee may be necessary to properly mark pipe crossing location. (DWR UCIP - W. Wylie) FIELD_STRUCT_DESC: Steel natural gas pipeline of an unknown size through the levee, at an unknown depth. Corrugated metal pipe (CMP) riser and gas line marker off the landside (LS) toe. FS Date: 6/23/2021

LS view: Toe from crown, no marker visible.

LS view: Marker visible across the road.

WS view: Toe from crown, no markers visible.

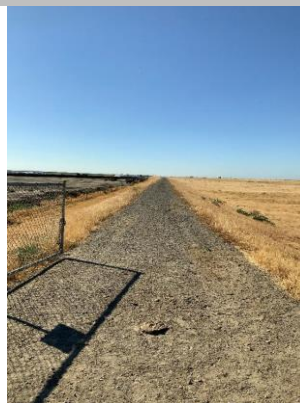
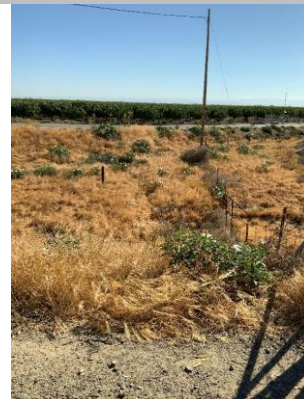
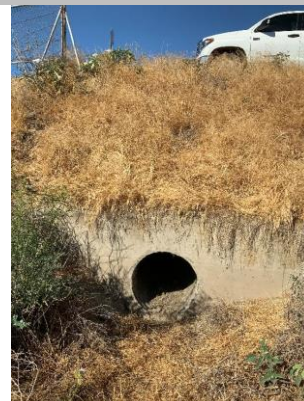
LM Start	<b>19.52</b>	Rating **	M	Issue No.	<b>1362</b>
LM End	<b>19.52</b>	Issue Type +	Ma	Location *	
Category	Supplemental		GPS Latitude/Longitude		
			Start	End	
Item	DWR UCIP LMA Responsibility		37.112953 °	37.112953 °	
			-120.559943 °	-120.559943 °	
DWR ID	19778

DS\_ID:19778  
 FS\_ID:69974  
 EP\_NO: N/A  
 Repair Type: Non-Urgent  
 EVAL Issue: Unauthorized Encroachment, installed decades prior  
 Crossing Status: Found  
 UCIP Comments: 06/23/2021 The record remains Non-Urgent. DWR DMP internal inspection has not found pipe integrity issues. LOF of crossing is less or equal to 4.0. Recommend next video inspection in 5 years. No permit was found authorizing this encroachment. CVFPB will need to review crossing to determine owner. The UCIP inspection was completed with GEI staff, P. Espinoza. (H. Dunn – GEI) 04/23/2014  
 Dense vegetation limits the inspector's visibility to identify signs of pipe failure (leaks) along the landward slope. Recommend removing vegetation along pipe alignment to conduct proper inspection of structure. Sediment buildup in pipe visible from landward side-- recommend contacting owner to clear pipe. (W. Wylie - DWR UCIP)  
 FIELD\_STRUCT\_DESC: 24-inch corrugated metal gravity drainage pipe through the levee, 9.7 feet below the crown. Flap gate on the waterside (WS) end. Concrete headwall on the landside (LS) end. Concrete U-shaped headwall on the WS end. [Additional Reference(s): DWR Levee Log, 2002 (HLM 19.50), listed as a 24-inch corrugated metal pipe (CMP). USACE San Joaquin O&M Manual, Unit 601 Part 1 (SJR601.1), 1967, Revised 25 May 2011, (HLM 19.50), listed as a 24-inch CMP]

Levee crown.

LS view: Toe from crown.

LS view: Headwall and slope at toe.

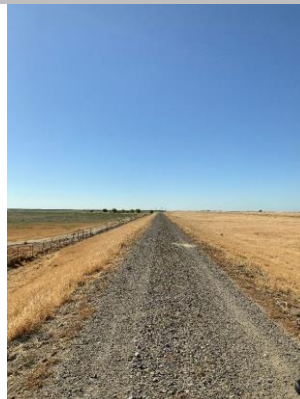
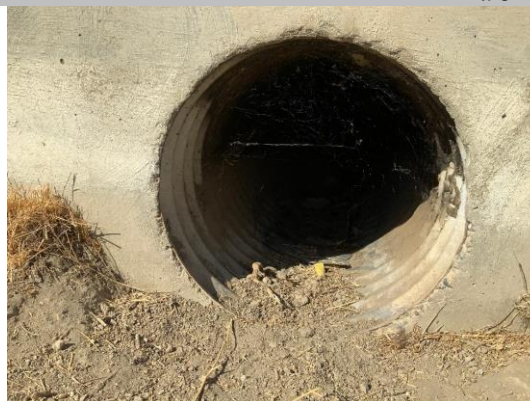
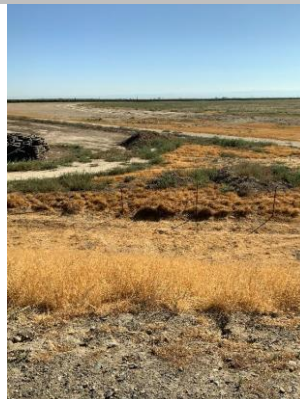
Comment Code					
Inspector Comment					
DS_ID:19779 FS_ID:70053 EP_NO: N/A Repair Type: Urgent EVAL Issue: Pipe Integrity Crossing Status: Found UCIP Comments: 06/23/2021 The record has been upgraded from No Action Needed to Urgent. DWR DMP internal inspection has found pipe integrity issues. LOF of crossing is greater than or equal to 5 and less than 6. Crossing will be monitored until funding becomes available to address the issues. WS flapgate has holes in it. LS pipe inlet has some minor debris buildup. No permit was found authorizing this encroachment. CVFPB will need to review crossing to determine owner. The UCIP inspection was completed with GEI staff, P. Espinoza. (H. Dunn – GEI) FIELD_STRUCT_DESC: 24-inch corrugated metal gravity drainage pipe through the levee, 10.3 feet below the crown. Flap gate on the waterside (WS) end. Concrete headwall on the landside (LS) end. Concrete U-shaped headwall on the WS end. [Additional Reference(s): DWR Levee Log, 2002 (HLM 19.83), listed as a 24-inch corrugated metal pipe (CMP). USACE San Joaquin O&M Manual, Unit 601 Part 1 (SJR601.1), 1967, Revised 25 May 2011, (HLM 19.84), listed as a 24-inch CMP] FS Date: 6/23/2021

Levee crown.

LS view: Closeup of pipe inlet at toe.

LS view: Toe from crown.

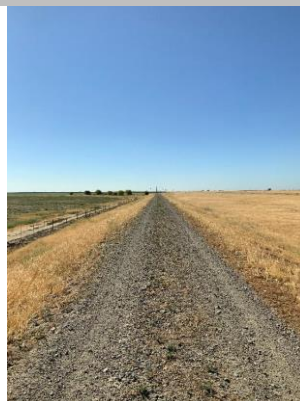
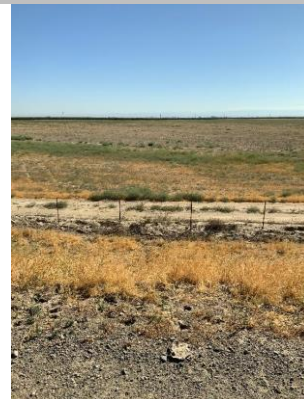
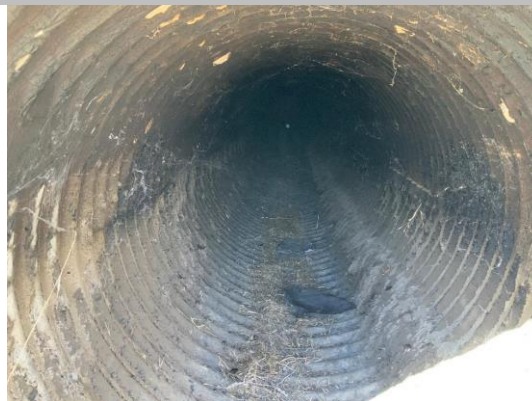
LM Start	<b>19.94</b>	Rating **	M	Issue No.	<b>1364</b>
LM End	<b>19.94</b>	Issue Type +	Ma	Location *	
Category	Supplemental		GPS Latitude/Longitude		
			Start	End	
Item	DWR UCIP LMA Responsibility		37.108426 °	37.108426 °	
			-120.554990 °	-120.554990 °	
DWR ID	19780

DS\_ID:19780  
 FS\_ID:69984  
 EP\_NO: N/A  
 Repair Type: Non-Urgent  
 EVAL Issue: Unauthorized Encroachment, installed decades prior  
 Crossing Status: Found  
 UCIP Comments: 06/23/2021 The record has been upgraded from No Action Needed to Non-Urgent. DWR DMP internal inspection has not found pipe integrity issues. LOF of crossing is less or equal to 4.0. Recommend next video inspection in 5 years. No permit was found authorizing this encroachment. CVFPB will need to review crossing to determine owner. The UCIP inspection was completed with GEI staff, P. Espinoza. (H. Dunn – GEI)  
 FIELD\_STRUCT\_DESC: 36-inch corrugated metal gravity drainage pipe through the levee, 9.8 feet below the crown. Flap gate on the waterside (WS) end. Concrete headwall on the landside (LS) end. Concrete U-shaped headwall on the WS end. [Additional Reference(s): DWR Levee Log, 2002 (HLM 19.92), listed as a 36-inch corrugated metal pipe (CMP). USACE San Joaquin O&M Manual, Unit 601 Part 1 (SJR601.1), 1967, Revised 25 May 2011, (HLM 19.92), listed as a 36-inch CMP].

Levee crown.

LS view: Toe from crown.

LS view: Inside pipe inlet at toe.

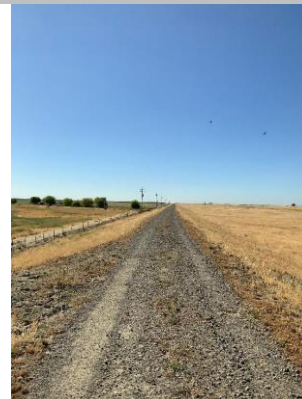
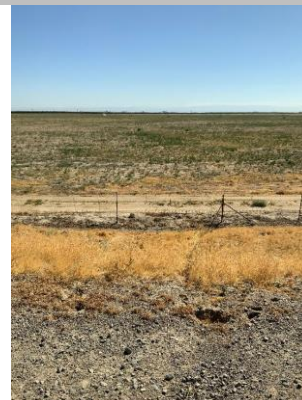
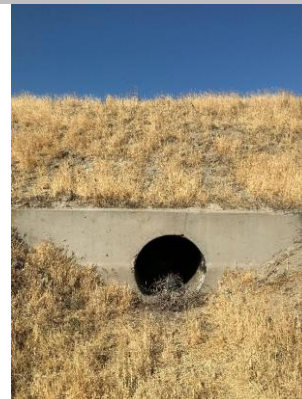
Comment Code						
Inspector Comment						
DS_ID:19781 FS_ID:69985 EP_NO: N/A Repair Type: Non-Urgent EVAL Issue: Unauthorized Encroachment, installed decades prior Crossing Status: Found UCIP Comments: 06/23/2021 The record has been upgraded from No Action Needed to Non-Urgent. DWR DMP internal inspection has not found pipe integrity issues. LOF of crossing is less or equal to 4.0. Recommend next video inspection in 5 years. No permit was found authorizing this encroachment. CVFPB will need to review crossing to determine owner. The UCIP inspection was completed with GEI staff, P. Espinoza. (H. Dunn – GEI) FIELD_STRUCT_DESC: 36-inch corrugated metal gravity drainage pipe through the levee, 9.9 feet below the crown. Flap gate on the waterside (WS) end. Concrete headwall on the landside (LS) end. Concrete U-shaped headwall on the WS end. [Additional Reference(s): DWR Levee Log, 2002 (HLM 20.04), listed as a 36-inch corrugated metal pipe (CMP). USACE San Joaquin O&M Manual, Unit 601 Part 1 (SJR601.1), 1967, Revised 25 May 2011, (HLM 20.05), listed as a 36-inch CMP] FS Date: 6/23/2021

Levee crown.

LS view: Toe from crown.

LS view: Slope and headwall from toe.

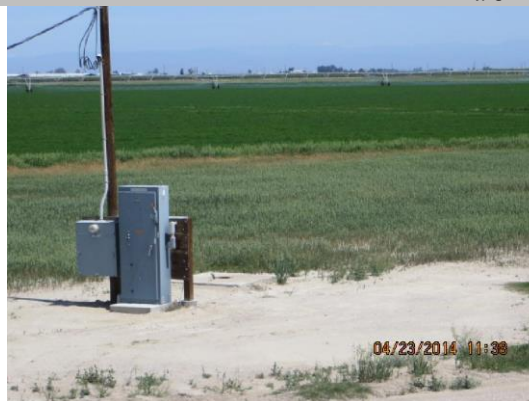
Photo 1 of 1 : UCIP\_FA\_2021\_34759\_62537.jpg

DS\_ID:19782  
 FS\_ID:34759  
 EP\_NO: 13828  
 Repair Type: Non-Urgent  
 EVAL Issue:  
 Crossing Status: Not Found  
 UCIP Comments:  
 FIELD\_STRUCT\_DESC: \*DELETE\* NOT INSTALLED THROUGH THE LEVEE. 24-inch steel irrigation pipe through the levee, 4.0 feet below the crown. Pump missing from pad on the landward side. Steel cutoff wall around pipe at center of levee. Siphon breaker on apex of pipe on landward shoulder. Pre-existing ditch runs from waterward toe to channel. Pipe extends from pump to the channel. Rock revetment on the cut slopes of the inlet channel. (Permit No. 13828-1988)  
 FS Date: 4/23/2014

Well head visible off LS toe.

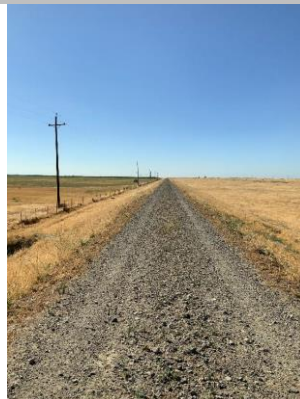
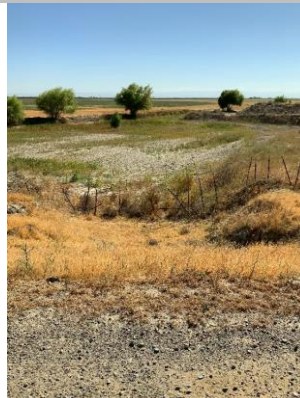
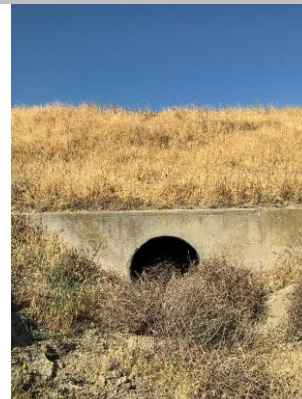
LM Start	<b>20.24</b>	Rating **	M	Issue No.	<b>1367 (cont)</b>
LM End	<b>20.24</b>	Issue Type +	Ma	Location *

Comment Code						
Inspector Comment						
DS_ID:19783 FS_ID:69986 EP_NO: N/A Repair Type: Non-Urgent EVAL Issue: Limited Inspection/No UCIP Evaluation Crossing Status: Found UCIP Comments: 06/23/2021 The record has been upgraded from No Action Needed to Non-Urgent. DWR DMP internal inspection has not found pipe integrity issues. LOF of crossing is less or equal to 4.0. Recommend next video inspection in 5 years. Limited inspection of LS pipe inlet due to tumbleweeds, recommend removal. No permit was found authorizing this encroachment. CVFPB will need to review crossing to determine owner. The UCIP inspection was completed with GEI staff, P. Espinoza. (H. Dunn – GEI) FIELD_STRUCT_DESC: 36-inch corrugated metal gravity drainage pipe through the levee, 10.6 feet below the crown. Flap gate on the waterside (WS) end. Concrete headwall on each end. [Additional Reference(s): DWR Levee Log, 2002 (HLM 20.18), listed as a 36-inch corrugated metal pipe (CMP). USACE San Joaquin O&M Manual, Unit 601 Part 1 (SJR601.1), 1967, Revised 25 May 2011, (HLM 20.18), listed as a 36-inch CMP] FS Date: 6/23/2021

Levee crown.

LS view: Toe from crown.

LS view: Slope and headwall from toe.

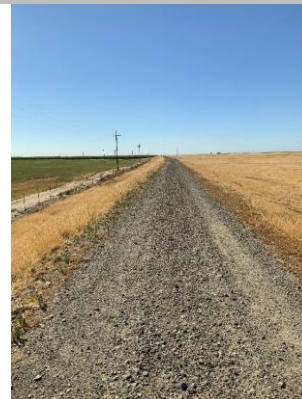
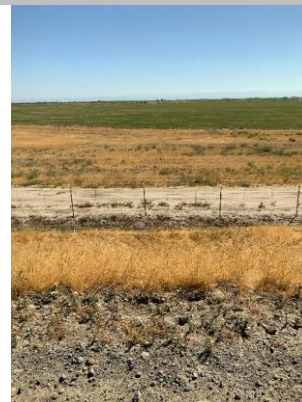
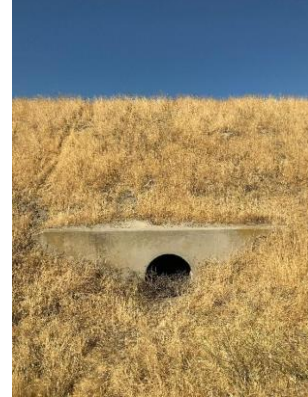
LM Start	<b>20.65</b>	Rating **	<b>U</b>	Issue No.	<b>1368 (cont)</b>
LM End	<b>20.65</b>	Issue Type +	<b>Ma</b>	Location *

Comment Code					
Inspector Comment					
DS_ID:19784 FS_ID:70054 EP_NO: N/A Repair Type: Urgent EVAL Issue: Pipe Integrity Crossing Status: Found UCIP Comments: 06/23/2021 The record has been upgraded from Non-Urgent to Urgent. DWR DMP internal inspection has found pipe integrity issues. LOF of crossing is is greater than or equal to 5 and less than 6. Crossing will be monitored until funding becomes available to address the issues. Some tumbleweed buildup at LS pipe inlet, recommend removal. No permit was found authorizing this encroachment. CVFPB will need to review crossing to determine owner. The UCIP inspection was completed with GEI staff, P. Espinoza. (H. Dunn – GEI)04/23/2014 Dense vegetation limits the inspector's visibility to identify signs of pipe failure (leaks) along the landward slope. Recommend removing vegetation along pipe alignment to conduct proper inspection of structure. (W. Wylie - DWR UCIP) FIELD_STRUCT_DESC: 24-inch corrugated metal gravity drainage pipe through the levee, 10.5 feet below the crown. Flap gate on the waterside (WS) end. Concrete headwall on the landside (LS) end. Concrete U-shaped headwall on the WS end. [Additional Reference(s): DWR Levee Log, 2002 (HLM 20.58), listed as a 24-inch corrugated metal pipe (CMP). USACE San Joaquin O&M Manual, Unit 601 Part 1 (SJR601.1), 1967, Revised 25 May 2011, (HLM 20.59), listed as a 24-inch CMP] FS Date: 6/23/2021

Levee crown.

LS view: Toe from crown.

LS view: Slope and headwall from toe.

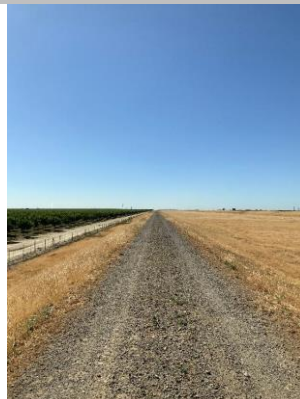
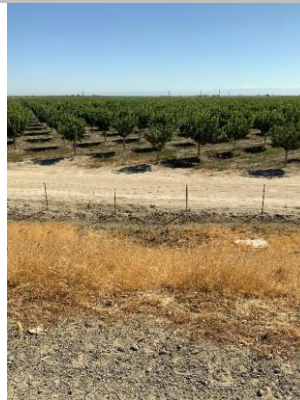
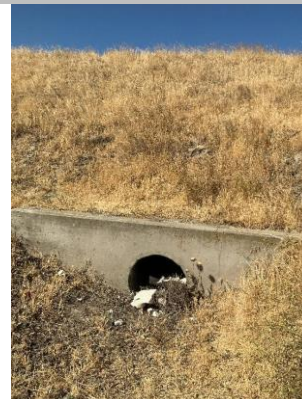
LM Start	<b>21.13</b>	Rating **	<b>U</b>	Issue No.	<b>1369 (cont)</b>
LM End	<b>21.13</b>	Issue Type +	<b>Ma</b>	Location *

DS\_ID:19785  
FS\_ID:70055  
EP\_NO: N/A  
Repair Type: Urgent  
EVAL Issue: Pipe Integrity  
Crossing Status: Found  
UCIP Comments: 06/23/2021 The record is being upgraded from Non-Urgent to Urgent. DWR DMP internal inspection has found pipe integrity issues. LOF of crossing is is greater than or equal to 5 and less than 6. Crossing will be monitored until funding becomes available to address the issues. Tumbleweed and debris covering LS pipe inlet, recommend removal. No permit was found authorizing this encroachment. CVFPB will need to review crossing to determine owner. The UCIP inspection was completed with GEI staff, P. Espinoza. (H. Dunn – GEI)04/23/2014 Dense vegetation limits the inspector's visibility to identify signs of pipe failure (leaks) along the landward slope. Recommend removing vegetation along pipe alignment to conduct proper inspection of structure. (W. Wylie - DWR UCIP)

Levee crown.

LS view: Toe from crown.

LS view: Slope and headwall from toe.

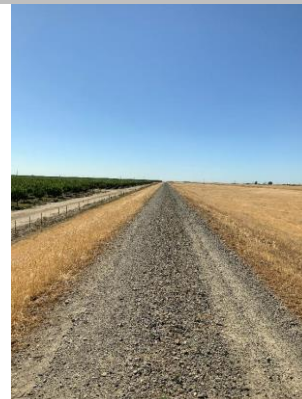
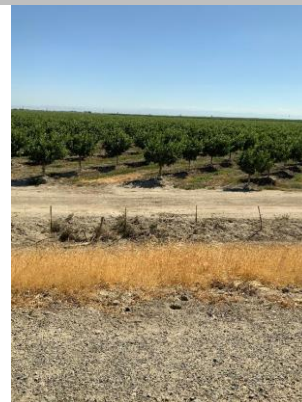
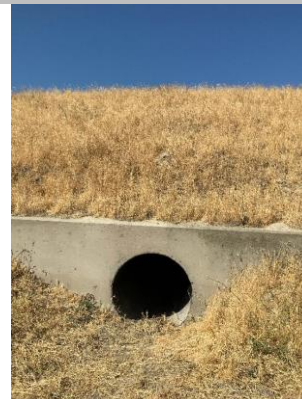
LM Start	<b>21.48</b>	Rating **	U	Issue No.	<b>1370 (cont)</b>
LM End	<b>21.48</b>	Issue Type +	Ma	Location *

Comment Code						
Inspector Comment						
DS_ID:19786 FS_ID:70056 EP_NO: N/A Repair Type: Urgent EVAL Issue: Pipe Integrity Crossing Status: Found UCIP Comments: 06/23/2021 The record has been upgraded from Non-Urgent to Urgent. DWR DMP internal inspection has found pipe integrity issues. LOF of crossing is is greater than or equal to 5 and less than 6. Crossing will be monitored until funding becomes available to address the issues. Potential hole in WS flapgate. Sand buildup around WS flapgate preventing it from opening easily, recommend removal. No permit was found authorizing this encroachment. CVFPB will need to review crossing to determine owner. The UCIP inspection was completed with GEI staff, P. Espinoza. (H. Dunn – GEI)04/23/2014 Dense vegetation limits the inspector's visibility to identify signs of pipe failure (leaks) along the landward slope. Recommend removing vegetation along pipe alignment to conduct proper inspection of structure. (W. Wylie - DWR UCIP) FIELD_STRUCT_DESC: 36-inch corrugated metal gravity drainage pipe through the levee, 12.7 feet below the crown. Flap gate on the waterside (WS) end. Concrete headwall on the landside (LS) end. Concrete U-shaped headwall on the WS end. [Additional Reference(s): DWR Levee Log, 2002 (HLM 21.43), listed as a 36-inch corrugated metal pipe (CMP). USACE San Joaquin O&M Manual, Unit 601 Part 1 (SJR601.1), 1967, Revised 25 May 2011, (HLM 21.42)] FS Date: 6/23/2021

Levee crown.

LS view: Toe from crown.

LS view: Slope and headwall at toe.

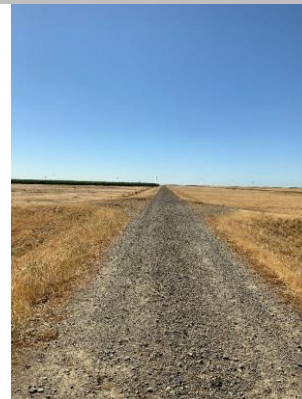
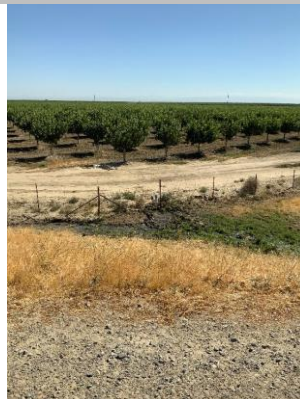
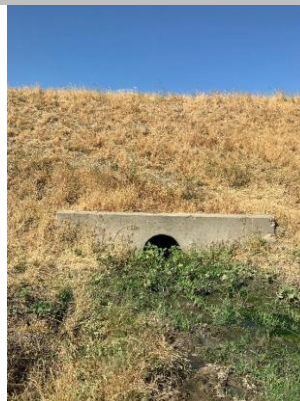
LM Start	<b>21.91</b>	Rating **	U	Issue No.	<b>1371 (cont)</b>
LM End	<b>21.91</b>	Issue Type +	Ma	Location *	
Category	Supplemental		GPS Latitude/Longitude		
			Start	End	
Item	DWR UCIP LMA Responsibility		37.087525 °	37.087525 °	
			-120.532827 °	-120.532827 °	
DWR ID	19787

Comment Code					
Inspector Comment					
DS_ID:19787 FS_ID:70057 EP_NO: N/A Repair Type: Urgent EVAL Issue: Pipe Integrity Crossing Status: Found UCIP Comments: 06/23/2021 The record has been upgraded from Non-Urgent to Urgent. DWR DMP internal inspection has found pipe integrity issues. LOF of crossing is is greater than or equal to 5 and less than 6. Crossing will be monitored until funding becomes available to address the issues. Standing water on both WS outlet and LS inlet, limiting closeup inspection on both sides. Water appeared to be leaking through the WS flapgate, even though it was closed. No permit was found authorizing this encroachment. CVFPB will need to review crossing to determine owner. The UCIP inspection was completed with GEI staff, P. Espinoza. (H. Dunn – GEI)04/23/2014 Dense vegetation limits the inspector's visibility to identify signs of pipe failure (leaks) along the landward slope. Recommend removing vegetation along pipe alignment to conduct proper inspection of structure. (W. Wylie - DWR UCIP) FIELD_STRUCT_DESC: 24-inch corrugated metal gravity drainage pipe through the levee, 12.4 feet below the crown. Flap gate on the waterside (WS) end. Concrete headwall on the landside (LS) end. Concrete U-shaped headwall on the WS end. [Additional Reference(s): DWR Levee Log, 2002 (HLM 21.81), listed as a 24-inch corrugated metal pipe (CMP). USACE San Joaquin O&M Manual, Unit 601 Part 1 (SJR601.1), 1967, Revised 25 May 2011, (HLM 21.81), listed as a 24-inch CMP] FS Date: 6/23/2021

Levee crown.

LS view: Toe from crown.

LS view: Slope and headwall from toe.
