## Flood Control Project Maintenance Levee Inspections

### Fall 2021 Levee Maintenance Deficiency Summary Report

#### San Joaquin River Basin

NA0010 Lower San Joaquin Levee District	Overall LMA Rating	Total LMA Miles							
	U	191.27							
Rated Item	Maintenance Deficiency				Enforcement		Design & System Obsolescence		
	M Miles	U Miles	M + 4U Miles	Threshold %	M Miles	U Miles	M Miles	U Miles	
<i>Earthen Levee</i>									
Vegetation	47.00	9.57	85.28	44.59%					
Trim / Thin Trees	0.10		0.10	0.05%					
Encroachments	0.23	0.02	0.31	0.16%	9.29	0.59			
Animal Control	7.67	2.19	16.43	8.59%					
Slope Stability	0.05	0.01	0.09	0.05%					
Erosion / Bank Caving	0.13	0.81	3.37	1.76%					
Crown Surface / Depressions / Rutting	0.01		0.01	0.01%					
Repair Gates	0.02	0.02	0.10	0.05%					
<i>Rivers, Channels &amp; Designated Floodways</i>									
Encroachments					0.01	0.01			
<i>Supplemental</i>									
DWR Erosion Survey	0.12	0.17	0.80	0.42%					
DWR UCIP Field Study					1.29	0.05			
DWR UCIP LMA Responsibility									
<i>LMA Totals:</i>	55.33	12.79	106.49	55.67%	10.59	0.65	0.00	0.00

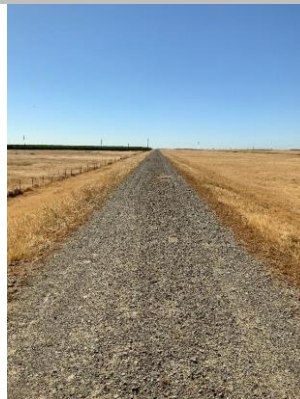
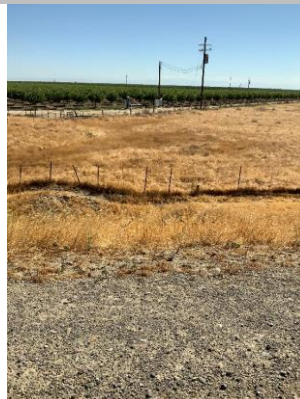
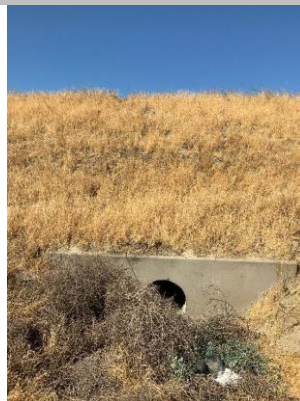
LM Start	21.95	Rating **	U	Issue No.	1372 (cont)	
LM End	21.95	Issue Type +	Ma	Location *		
Category	Supplemental			GPS Latitude/Longitude		
				Start	End	
Item	DWR UCIP LMA Responsibility			37.087108 °	37.087108 °	
				-120.532374 °	-120.532374 °	
DWR ID	19788

Comment Code					
Inspector Comment					
DS_ID:19788 FS_ID:70058 EP_NO: N/A Repair Type: Urgent EVAL Issue: Pipe Integrity Crossing Status: Found UCIP Comments: 06/23/2021 The record has been upgraded from Non-Urgent to Urgent. DWR DMP internal inspection has found pipe integrity issues. LOF of crossing is is greater than or equal to 5 and less than 6. Crossing will be monitored until funding becomes available to address the issues. Limited inspection of the LS pipe inlet due to dense tumbleweeds and vegetation, recommend removal. No permit was found authorizing this encroachment. CVFPB will need to review crossing to determine owner. The UCIP inspection was completed with GEI staff, P. Espinoza. (H. Dunn – GEI)04/23/2014 Dense vegetation limits the inspector's visibility to identify signs of pipe failure (leaks) along the landward slope. Recommend removing vegetation along pipe alignment to conduct proper inspection of structure. (W. Wylie - DWR UCIP) FIELD_STRUCT_DESC: 24-inch corrugated metal gravity drainage pipe through the levee, 10.7 feet below the crown. Flap gate on the waterside (WS) end. Concrete headwall on the landside (LS) end. Concrete U-shaped headwall on the WS end. [Additional Reference(s): DWR Levee Log, 2002 (HLM 21.85), listed as a 24-inch corrugated metal pipe (CMP). USACE San Joaquin O&M Manual, Unit 601 Part 1 (SJR601.1), 1967, Revised 25 May 2011, (HLM 21.85), listed as a 24-inch CMP]. FS Date: 6/23/2021

Levee crown.

LS view: Toe from crown.

LS view: Slope and headwall from toe.

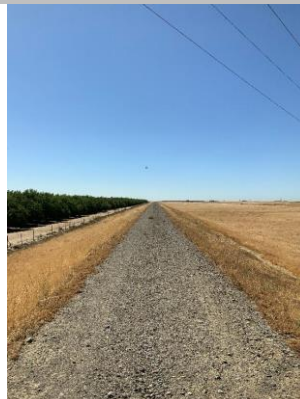
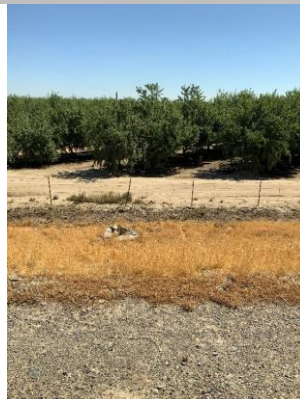
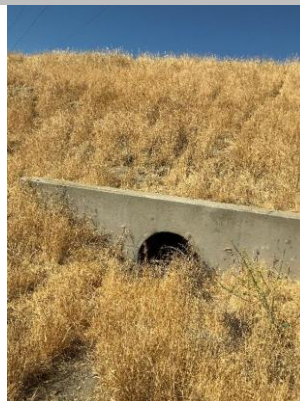
LM Start	<b>22.28</b>	Rating **	U	Issue No.	<b>1373 (cont)</b>
LM End	<b>22.28</b>	Issue Type +	Ma	Location *	
Category	Supplemental		GPS Latitude/Longitude		
			Start	End	
Item	DWR UCIP LMA Responsibility		37.083410 °	37.083410 °	
			-120.528356 °	-120.528356 °	
DWR ID	19789

Comment Code						
Inspector Comment						
DS_ID:19789 FS_ID:70141 EP_NO: N/A Repair Type: Urgent EVAL Issue: Pipe Integrity Crossing Status: Found UCIP Comments: 06/23/2021 The record has been upgraded from Non-Urgent to Urgent. DWR DMP internal inspection has found pipe integrity issues. LOF of crossing is is greater than or equal to 5 and less than 6. Crossing will be monitored until funding becomes available to address the issues. Some vegetation growing over LS pipe inlet, recommend removal. No permit was found authorizing this encroachment. CVFPB will need to review crossing to determine owner. The UCIP inspection was completed with GEI staff, P. Espinoza. (H. Dunn – GEI)04/23/2014 Dense vegetation limits the inspector's visibility to identify signs of pipe failure (leaks) along the landward slope. Recommend removing vegetation along pipe alignment to conduct proper inspection of structure. Sediment buildup in pipe visible from landward side--recommend contacting owner to clear pipe. (W. Wylie - DWR UCIP) FIELD_STRUCT_DESC: 24-inch corrugated metal gravity drainage pipe through the levee, 10.2 feet below the crown. Flap gate on the waterside (WS) end. Concrete headwall on the landside (LS) end. Concrete U-shaped headwall on the WS end. [Additional Reference(s): DWR Levee Log, 2002 (HLM 22.18), listed as a 24-inch corrugated metal pipe (CMP). USACE San Joaquin O&M Manual, Unit 601 Part 1 (SJR601.1), 1967, Revised 25 May 2011, (HLM 22.19), listed as a 24-inch CMP]. FS Date: 6/23/2021

Levee crown.

LS view: Toe from crown.

LS view: Headwall and slope from toe.

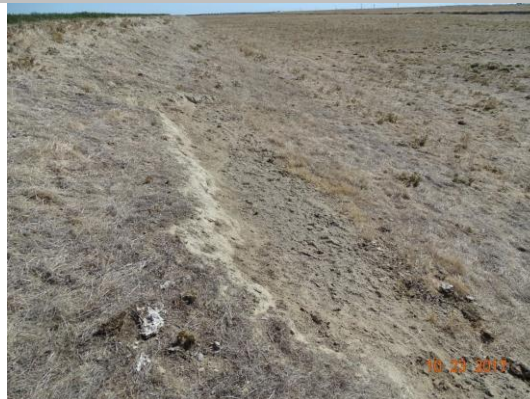
Photo 1 of 1 : FA\_2021\_NA0010\_123\_121\_20210830\_00023.jpg

LM Start	22.35	Rating **	M	Issue No.	121
LM End	22.35	Issue Type +	Ma	Location *	WS
Category	Earthen Levee			GPS Latitude/Longitude	
				Start	End
Item	Animal Control			37.082696 °	37.082696 °
				-120.527620 °	-120.527620 °
DWR ID	DWR_NA0010_05_f _ 2017_121				
Comment Code					
A2 : Repair the levee slope damaged by livestock and prevent large animal access.					
Inspector Comment					
Waterside slope damaged by animal traffic.

Looking southeast at the waterside slope.

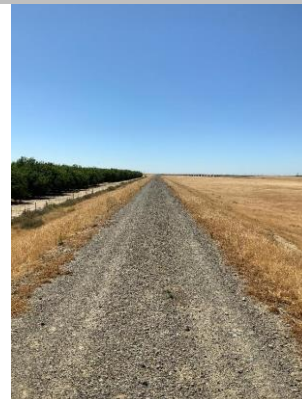
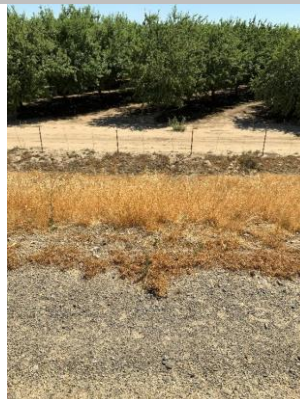
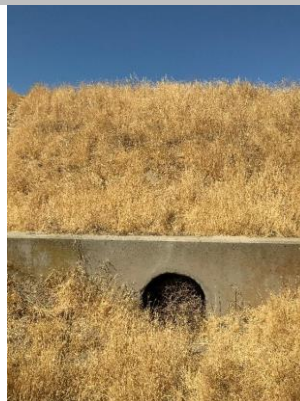
LM Start	<b>22.55</b>	Rating **	U	Issue No.	<b>1374 (cont)</b>
LM End	<b>22.55</b>	Issue Type +	Ma	Location *	
Category	Supplemental		GPS Latitude/Longitude		
			Start	End	
Item	DWR UCIP LMA Responsibility		37.080486 °	37.080486 °	
			-120.525180 °	-120.525180 °	
DWR ID	19790

Comment Code						
Inspector Comment						
DS_ID:19790 FS_ID:70190 EP_NO: N/A Repair Type: Urgent EVAL Issue: Pipe Integrity Crossing Status: Found UCIP Comments: 06/23/2021 The record has been upgraded from Non-Urgent to Urgent. DWR DMP internal inspection has found pipe integrity issues. LOF of crossing is greater than or equal to 5 and less than 6. Crossing will be monitored until funding becomes available to address the issues. Possible hole in WS flapgate. No permit was found authorizing this encroachment. CVFPB will need to review crossing to determine owner. The UCIP inspection was completed with GEI staff, P. Espinoza. (H. Dunn – GEI)04/23/2014 Dense vegetation limits the inspector's visibility to identify signs of pipe failure (leaks) along the landward slope. Recommend removing vegetation along pipe alignment to conduct proper inspection of structure. Sediment buildup in pipe visible from landward side--recommend contacting owner to clear pipe. (W. Wylie - DWR UCIP) FIELD_STRUCT_DESC: 24-inch corrugated metal gravity drainage pipe through the levee, 10.4 feet below the crown. Flap gate on the waterside (WS) end. Concrete headwall on the landside (LS) end. Concrete U-shaped headwall on the WS end. [Additional Reference(s): DWR Levee Log, 2002 (HLM 22.46), listed as a 24-inch corrugated metal pipe (CMP). USACE San Joaquin O&M Manual, Unit 601 Part 1 (SJR601.1), 1967, Revised 25 May 2011, (HLM 22.46), listed as a 24-inch CMP] FS Date: 6/23/2021

Levee crown.

LS view: Toe from crown.

LS view: Slope and headwall at toe.

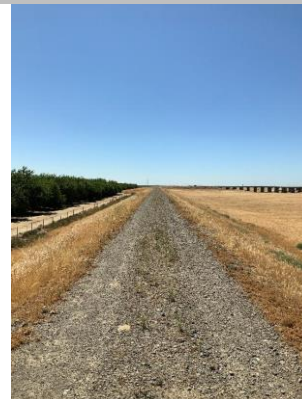
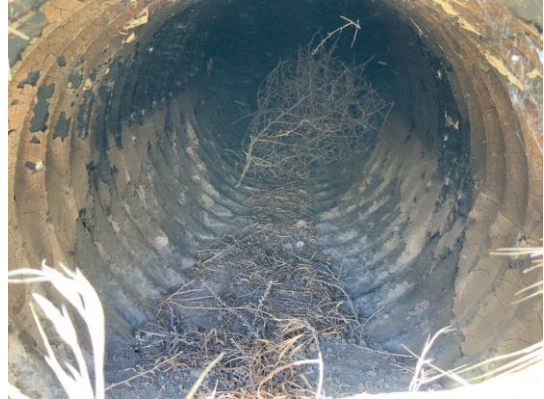
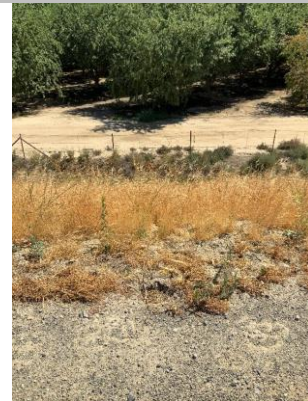
Photo 1 of 3 : UCIP\_FA\_2021\_70061\_104227.jpg

Comment Code					
Inspector Comment					
DS_ID:19791 FS_ID:70061 EP_NO: N/A Repair Type: Urgent EVAL Issue: Pipe Integrity Crossing Status: Found UCIP Comments: 06/23/2021 The record has been upgraded from Non-Urgent to Urgent. DWR DMP internal inspection has found pipe integrity issues. LOF of crossing is greater than or equal to 5 and less than 6. Crossing will be monitored until funding becomes available to address the issues. Deterioration of the underside of the WS flapgate. No permit was found authorizing this encroachment. CVFPB will need to review crossing to determine owner. The UCIP inspection was completed with GEI staff, P. Espinoza. (H. Dunn – GEI)04/23/2014 Dense vegetation limits the inspector's visibility to identify signs of pipe failure (leaks) along the landward slope. Recommend removing vegetation along pipe alignment to conduct proper inspection of structure. Sediment buildup in pipe visible from landward side--recommend contacting owner to clear pipe. (W. Wylie - DWR UCIP) FIELD_STRUCT_DESC: 24-inch corrugated metal gravity drainage pipe through the levee, 12.2 feet below the crown. Flap gate on the waterside (WS) end. Concrete headwall on the landside (LS) end. Concrete U-shaped headwall on the WS end. [Additional Reference(s): DWR Levee Log, 2002 (HLM 22.79), listed as a 24-inch corrugated metal pipe (CMP). USACE San Joaquin O&M Manual, Unit 601 Part 1 (SJR601.1), 1967, Revised 25 May 2011, (HLM 22.79), listed as a 24-inch CMP] FS Date: 6/23/2021

Levee crown.

LS view: Inside pipe inlet at toe.

LS view: Toe from crown.

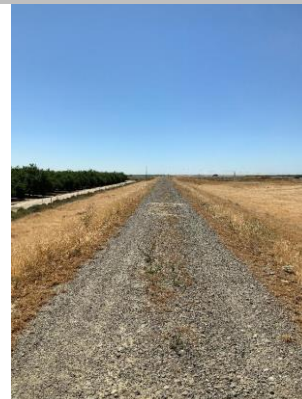
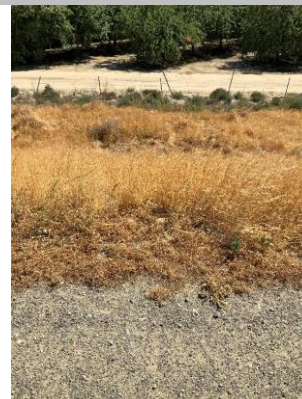
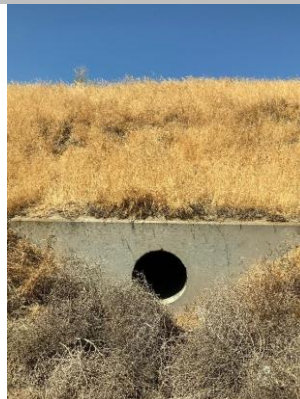
Photo 1 of 3 : UCIP\_FA\_2021\_70062\_104235.jpg

Comment Code						
Inspector Comment						
DS_ID:19792 FS_ID:70062 EP_NO: N/A Repair Type: Urgent EVAL Issue: Pipe Integrity Crossing Status: Found UCIP Comments: 06/23/2021 The record has been upgraded from Non-Urgent to Urgent. DWR DMP internal inspection has found pipe integrity issues. LOF of crossing is greater than or equal to 5 and less than 6. Crossing will be monitored until funding becomes available to address the issues. Deterioration of the underside of the WS flapgate. No permit was found authorizing this encroachment. CVFPB will need to review crossing to determine owner. The UCIP inspection was completed with GEI staff, P. Espinoza. (H. Dunn – GEI)04/23/2014 Dense vegetation limits the inspector's visibility to identify signs of pipe failure (leaks) along the landward slope. Recommend removing vegetation along pipe alignment to conduct proper inspection of structure. (W. Wylie - DWR UCIP) FIELD_STRUCT_DESC: 24-inch corrugated metal gravity drainage pipe through the levee, 11.1 feet below the crown. Flap gate on the waterside (WS) end. Concrete headwall on the landside (LS) end. Concrete U-shaped headwall on the WS end. [Additional Reference(s): DWR Levee Log, 2002 (HLM 22.93), listed as a 24-inch corrugated metal pipe (CMP). USACE San Joaquin O&M Manual, Unit 601 Part 1 (SJR601.1), 1967, Revised 25 May 2011, (HLM 22.94), listed as a 24-inch CMP] FS Date: 6/23/2021

Levee crown.

LS view: Toe from crown.

LS view: Headwall and slope from toe.

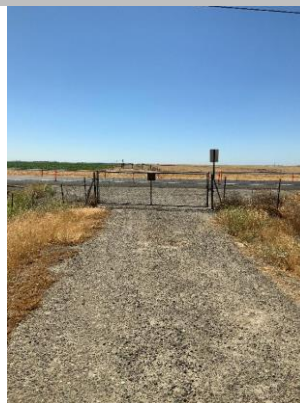
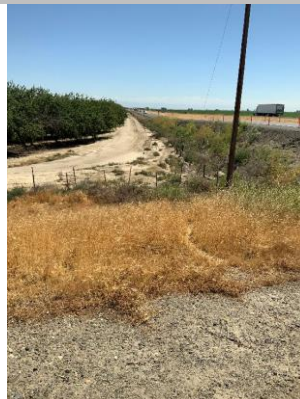
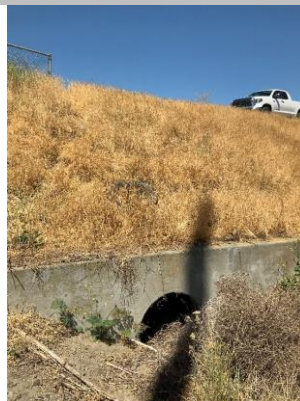
Photo 1 of 3 : UCIP\_FA\_2021\_70040\_104335.jpg

DS\_ID:19793  
 FS\_ID:70040  
 EP\_NO: N/A  
 Repair Type: Non-Urgent  
 EVAL Issue: Maintenance Compliance Issue  
 Crossing Status: Found  
 UCIP Comments: 06/23/2021 The record remains Non-Urgent. DWR DMP internal inspection has not found pipe integrity issues. LOF of crossing is less or equal to 4.0. Recommend next video inspection in 5 years. Some vegetation covering LS inlet and WS flapgate, recommend removal on both ends. No permit was found authorizing this encroachment. CVFPB will need to review crossing to determine owner. The UCIP inspection was completed with GEI staff, P. Espinoza. (H. Dunn – GEI) 04/23/2014 Debris blocking closure of outlet. Dense vegetation limits the inspector's visibility to identify signs of pipe failure (leaks) along the waterward and landward slopes. Recommend removing vegetation along pipe alignment to conduct proper inspection of structure. (W. Wylie - DWR UCIP)

FIELD\_STRUCT\_DESC: 24-inch corrugated metal gravity drainage pipe through the levee, 11.5 feet below the crown. Flap gate on the waterside (WS) end. Concrete headwall on the landside (LS) end. Concrete U-shaped headwall on the WS end. [Additional Reference(s): DWR Levee Log, 2002 (HLM 23.06), listed as a 24-inch corrugated metal pipe (CMP)]  
 FS Date: 6/23/2021

Levee crown.

LS view: Toe from crown.

LS view: Slope and headwall from toe.

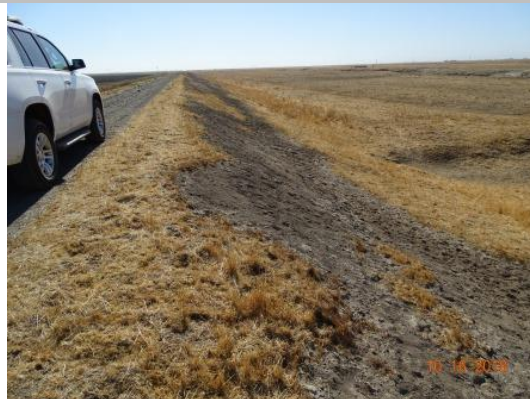
Photo 1 of 1 : FA\_2021\_NA0010\_123\_160\_20210830\_00047.jpg

LM Start	23.24	Rating **	A/W	Issue No.	160
LM End	23.68	Issue Type +	Ma	Location *	WS
Category	Earthen Levee			GPS Latitude/Longitude	
				Start	End
Item	Animal Control			37.073064 °	37.068260 °
				-120.516771 °	-120.511583 °
DWR ID	DWR_NA0010_05_f_2018_160				
Comment Code					
A2 : Repair the levee slope damaged by livestock and prevent large animal access.					
Inspector Comment					
There is slope damage caused by livestock on waterside.

Slope damage cause by livestock foot traffic. (Fall 2018)

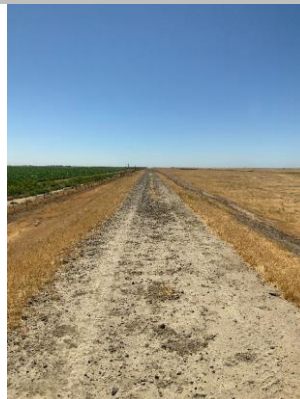
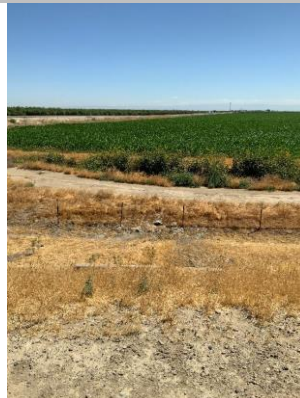
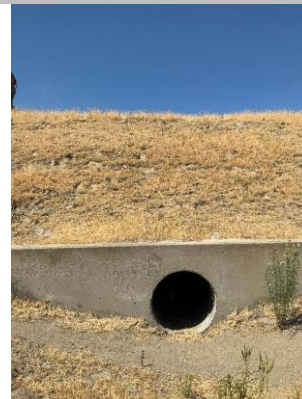
Photo 1 of 3 : UCIP\_FA\_2021\_70042\_104342.jpg

DS\_ID:19794  
FS\_ID:70042  
EP\_NO: N/A  
Repair Type: Non-Urgent  
EVAL Issue: Unauthorized Encroachment, installed decades prior  
Crossing Status: Found  
UCIP Comments: 06/23/2021 The record has been upgraded from No Action Needed to Non-Urgent. DWR DMP internal inspection has not found pipe integrity issues. LOF of crossing is less or equal to 4.0. Recommend next video inspection in 5 years. No permit was found authorizing this encroachment. CVFPB will need to review crossing to determine owner. The UCIP inspection was completed with GEI staff, P. Espinoza. (H. Dunn – GEI)  
FIELD\_STRUCT\_DESC: 30-inch corrugated metal gravity drainage pipe through the levee, 11.6 feet below the crown. Flap gate on the waterside (WS) end. Concrete headwall on the landside (LS) end. Concrete U-shaped headwall on the WS end. [Additional Reference(s): DWR Levee Log, 2002 (HLM 23.14), listed as a 30-inch corrugated metal pipe (CMP). USACE San Joaquin O&M Manual, Unit 601 Part 1 (SJR601.1), 1967, Revised 25 May 2011, (HLM 23.15), listed as a 30-inch CMP]

Levee crown.

LS view: Toe from crown.

LS view: Slope and headwall from toe.

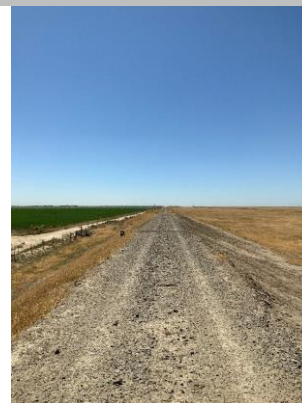
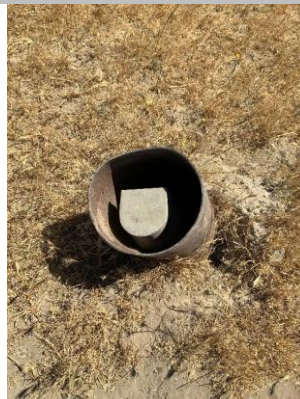
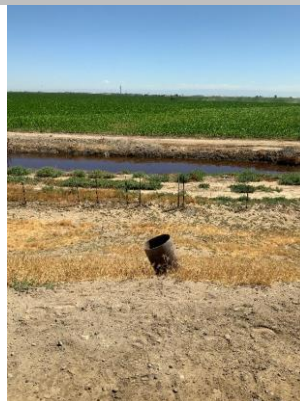
Photo 1 of 3 : UCIP\_FA\_2021\_70191\_104367.jpg

DS\_ID:19795  
 FS\_ID:70191  
 EP\_NO: 13829  
 Repair Type: Urgent  
 EVAL Issue: Flood Risk  
 Crossing Status: Found  
 UCIP Comments: 06/23/2021 The record has been upgraded from No Action Needed to Urgent. Appears abandoned, WS pipe is missing parts as there are open holes without flapgates that would potentially allow water through, see photos. Open on both ends. Confirm with owner on the status of this pipe. The UCIP inspection was completed with GEI staff, P. Espinoza. (H. Dunn – GEI)  
 FIELD\_STRUCT\_DESC: 1 of 2: 16-inch coated steel irrigation discharge pipe through the levee, 4 feet below the crown. Steel cutoff wall around the pipe at the center of the levee. Slant pump off the waterside (WS) toe. Siphon breaker in a 10-inch steel pipe riser on the landside (LS) shoulder. A preexisting ditch runs from the WS toe to the channel. Rock revetment on the cut slopes of the inlet channel. (Plans to install a pump with a 16-inch discharge pipe through the levee to provide irrigation water authorized under Permit No. 13829, 1984 - John H. Sorenson, Inc.). [Additional Reference(s): DWR Levee Log, 2002 (HLM 23.51), listed as a 16-inch pipe]

Levee crown.

LS view: Closeup of siphon breaker on slope.

LS view: Toe from crown.

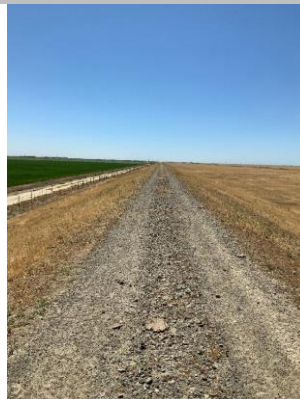
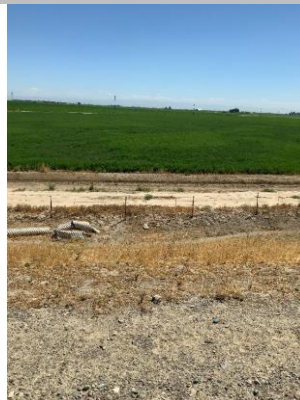
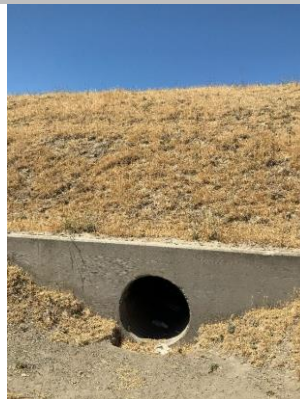
Photo 1 of 3 : UCIP\_FA\_2021\_70144\_104379.jpg

Comment Code					
Inspector Comment					
DS_ID:19796 FS_ID:70144 EP_NO: N/A Repair Type: Urgent EVAL Issue: Pipe Integrity Crossing Status: Found UCIP Comments: 06/23/2021 The record has been upgraded from Non-Urgent to Urgent. DWR DMP internal inspection has found pipe integrity issues. LOF of crossing is greater than or equal to 5 and less than 6. Crossing will be monitored until funding becomes available to address the issues. No permit was found authorizing this encroachment. CVFPB will need to review crossing to determine owner. The UCIP inspection was completed with GEI staff, P. Espinoza. (H. Dunn – GEI)03/25/2014 Sediment buildup in pipe visible from landward side-- recommend contacting owner to clear pipe. (W. Wylie - DWR UCIP) FIELD_STRUCT_DESC: 30-inch corrugated metal gravity drainage pipe through the levee, 12.1 feet below the crown. Flap gate on the waterside (WS) end. Concrete U-shaped headwall on the WS end. [Additional Reference(s): DWR Levee Log, 2002 (HLM 23.61), listed as a 30-inch corrugated metal pipe (CMP). USACE San Joaquin O&M Manual, Unit 601 Part 1 (SJR601.1), 1967, Revised 25 May 2011, (HLM 23.62), listed as a 30-inch CMP] FS Date: 6/23/2021

Levee crown.

LS view: Toe from crown.

LS view: Slope and headwall from toe.

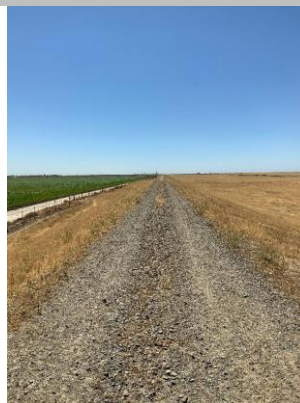
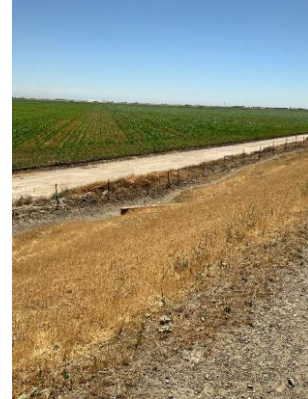
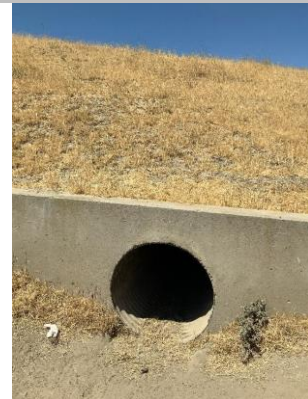
Photo 1 of 3 : UCIP\_FA\_2021\_70145\_104386.jpg

DS\_ID:19797  
 FS\_ID:70145  
 EP\_NO: N/A  
 Repair Type: Urgent  
 EVAL Issue: Pipe Integrity  
 Crossing Status: Found  
 UCIP Comments: 06/23/2021 The record has been upgraded from Non-Urgent to Urgent. DWR DMP internal inspection has found pipe integrity issues. LOF of crossing is greater than or equal to 5 and less than 6. Crossing will be monitored until funding becomes available to address the issues. Small hole seen in the front of the WS flapgate. No permit was found authorizing this encroachment. CVFPB will need to review crossing to determine owner. The UCIP inspection was completed with GEI staff, P. Espinoza. (H. Dunn – GEI)03/25/2014 Minor sediment/debris buildup in pipe visible from landward side--recommend contacting owner to clear pipe. (W. Wylie - DWR UCIP)  
 FIELD\_STRUCT\_DESC: 36-inch corrugated metal gravity drainage pipe through the levee, 12.1 feet below the crown. Flap gate on the waterside (WS) end. Concrete headwall on the landside (LS) end. Concrete U-shaped headwall on the WS end. [Additional Reference(s): DWR Levee Log, 2002 (HLM 23.92), listed as a 36-inch corrugated metal pipe (CMP). USACE San Joaquin O&M Manual, Unit 601 Part 1 (SJR601.1), 1967, Revised 25 May 2011, (HLM 23.85), listed as a 36-inch CMP]

Levee crown.

LS view: Toe from crown.

LS view: Slope and headwall from toe.

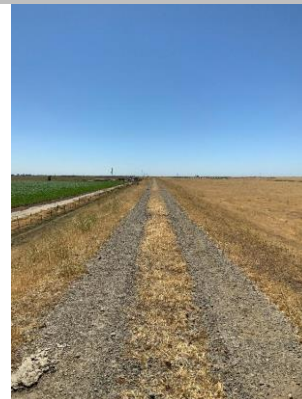
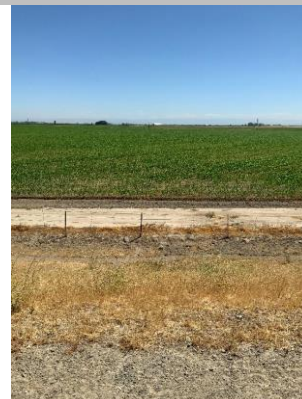
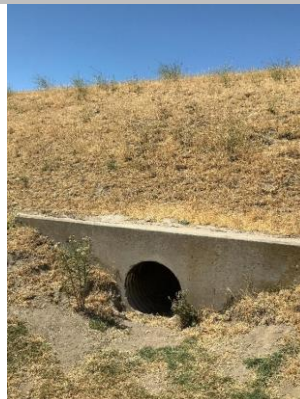
Photo 1 of 3 : UCIP\_FA\_2021\_70083\_104393.jpg

DS\_ID:19798  
FS\_ID:70083  
EP\_NO: N/A  
Repair Type: Non-Urgent  
EVAL Issue: Unauthorized Encroachment, installed decades prior  
Crossing Status: Found  
UCIP Comments: 06/23/2021 The record remains Non-Urgent. DWR DMP internal inspection has not found pipe integrity issues. LOF of crossing is less or equal to 4.0. Recommend next video inspection in 5 years. No permit was found authorizing this encroachment. CVFPB will need to review crossing to determine owner. The UCIP inspection was completed with GEI staff, P. Espinoza. (H. Dunn – GEI) 03/25/2014 Dense vegetation limits the inspector's visibility to identify signs of pipe failure (leaks) along the landward slope. Recommend removing vegetation along pipe alignment to conduct proper inspection of structure. (W. Wylie - DWR UCIP)  
FIELD\_STRUCT\_DESC: 24-inch corrugated metal gravity drainage pipe through the levee, 11.2 feet below the crown. Flap gate on the waterside (WS) end. Concrete headwall on the landside (LS) end. Concrete U-shaped headwall on the WS end. [Additional Reference(s): DWR Levee Log, 2002 (HLM 24.18), listed as a 24-inch corrugated metal pipe (CMP). USACE San Joaquin O&M Manual, Unit 601 Part 1 (SJR601.1), 1967, Revised 25 May 2011, (HLM 24.18), listed as a 24-inch CMP]

Levee crown.

LS view: Toe from crown.

LS view: Slope and headwall from toe.

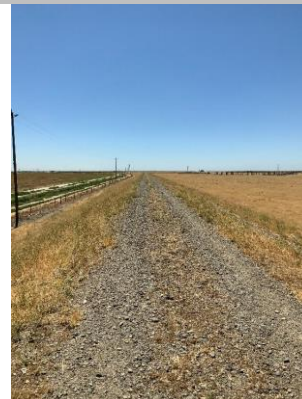
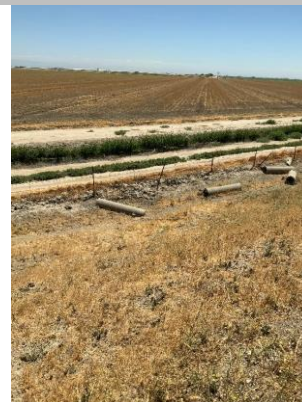
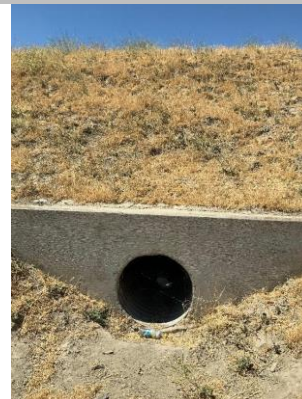
Photo 1 of 3 : UCIP\_FA\_2021\_70146\_104402.jpg

DS\_ID:19799  
FS\_ID:70146  
EP\_NO: N/A  
Repair Type: Urgent  
EVAL Issue: Pipe Integrity  
Crossing Status: Found  
UCIP Comments: 06/23/2021 The record has been upgraded from Non-Urgent to Urgent. DWR DMP internal inspection has found pipe integrity issues. LOF of crossing is greater than or equal to 5 and less than 6. Crossing will be monitored until funding becomes available to address the issues. Hole visible on underneath of flapgate on WS. No permit was found authorizing this encroachment. CVFPB will need to review crossing to determine owner. The UCIP inspection was completed with GEI staff, P. Espinoza. (H. Dunn – GEI)03/25/2014 Dense vegetation limits the inspector's visibility to identify signs of pipe failure (leaks) along the landward slope. Recommend removing vegetation along pipe alignment to conduct proper inspection of structure. (W. Wylie - DWR UCIP)  
FIELD\_STRUCT\_DESC: 24-inch corrugated metal gravity drainage pipe through the levee, 11.2 feet below the crown. Flap gate on the waterside (WS) end. Concrete headwall on the landside (LS) end. Concrete U-shaped headwall on the WS end. [Additional Reference(s): DWR Levee Log, 2002 (HLM 24.46), listed as a 24-inch corrugated metal pipe (CMP). USACE San Joaquin O&M Manual, Unit 601 Part 1 (SJR601.1), 1967, Revised 25 May 2011, (HLM 24.46), listed as a 24-inch CMP]

Levee crown.

LS view: Toe from crown.

LS view: Slope and headwall from toe.

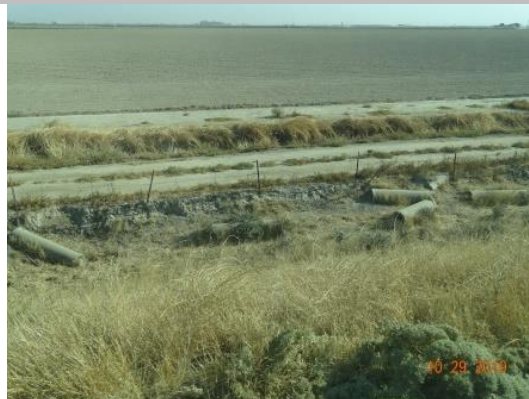
Photo 1 of 1 : FA\_2021\_NA0010\_123\_175\_20210830\_00052.jpg

LM Start	24.56	Rating **	M	Issue No.	175
LM End	24.56	Issue Type +	En	Location *	LS
Category	Earthen Levee			GPS Latitude/Longitude	
				Start	End
Item	Encroachments			37.058672 °	37.058672 °
				-120.501218 °	-120.501218 °
DWR ID	DWR_NA0010_05_f _ 2019_175				
Comment Code					
PI : Pipe					
Inspector Comment					
Concrete pipe left on landside toe.

Sections of concrete pipe left along the landside toe. (Fall 2019)

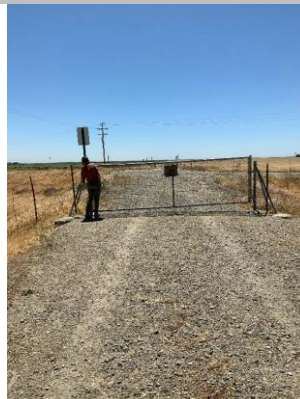
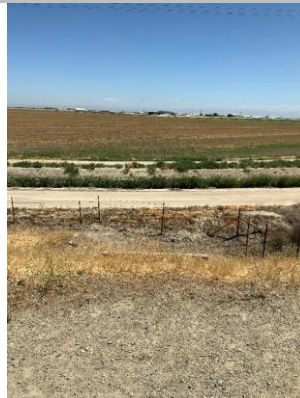
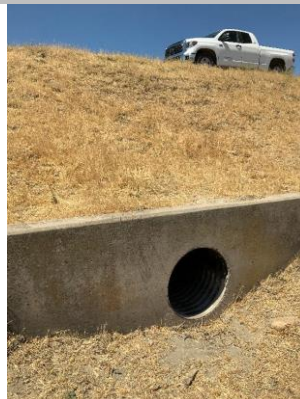
DS\_ID:19800  
FS\_ID:70085  
EP\_NO: N/A  
Repair Type: Non-Urgent  
EVAL Issue: Unauthorized Encroachment, installed decades prior  
Crossing Status: Found  
UCIP Comments: 06/23/2021 The record has been upgraded from No Action Needed to Non-Urgent. DWR DMP internal inspection has not found pipe integrity issues. LOF of crossing is less or equal to 4.0. Recommend next video inspection in 5 years. No permit was found authorizing this encroachment. CVFPB will need to review crossing to determine owner. The UCIP inspection was completed with GEI staff, P. Espinoza. (H. Dunn – GEI)  
FIELD\_STRUCT\_DESC: 24-inch corrugated metal gravity drainage pipe through the levee, 10.7 feet below the crown. Flap gate on the waterside (WS) end. Concrete headwall on the landside (LS) end. Concrete U-shaped headwall on the WS end. [Additional Reference(s): DWR Levee Log, 2002 (HLM 24.82), listed as a 24-inch corrugated metal pipe (CMP). USACE San Joaquin O&M Manual, Unit 601 Part 1 (SJR601.1), 1967, Revised 25 May 2011, (HLM 24.82), listed as a 24-inch CMP]

Levee crown.

LS view: Toe from crown.

LS view: Slope and headwall from toe.

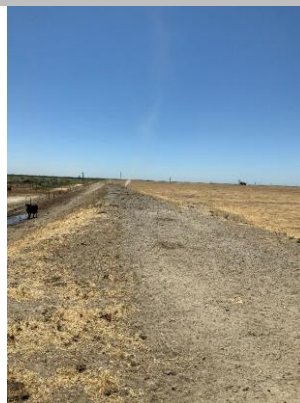
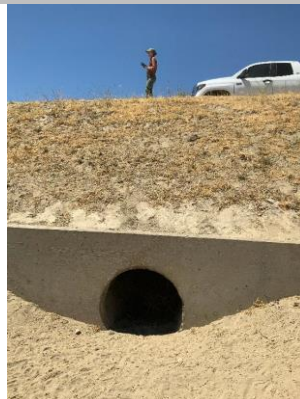
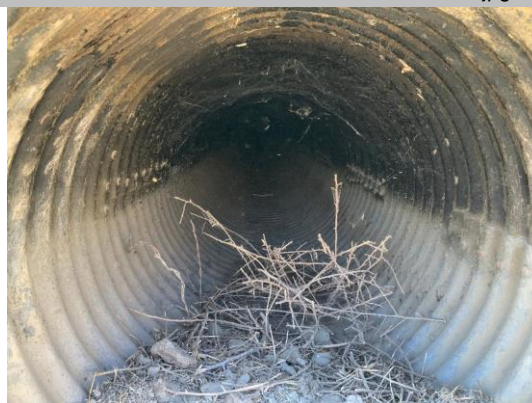
DS\_ID:19801  
 FS\_ID:70168  
 EP\_NO: N/A  
 Repair Type: Non-Urgent  
 EVAL Issue: Unauthorized Encroachment, installed decades prior  
 Crossing Status: Found  
 UCIP Comments: 06/23/2021 The record has been upgraded from No Action Needed to Non-Urgent. DWR DMP internal inspection has not found pipe integrity issues. LOF of crossing is less or equal to 4.0. Recommend next video inspection in 5 years. No permit was found authorizing this encroachment. CVFPB will need to review crossing to determine owner. The UCIP inspection was completed with GEI staff, P. Espinoza. (H. Dunn – GEI)  
 FIELD\_STRUCT\_DESC: 30-inch corrugated metal gravity drainage pipe through the levee, 10.9 feet below the crown. Flap gate on the waterside (WS) end. Concrete headwall on the landside (LS) end. Concrete U-shaped headwall on the WS end. [Additional Reference(s): DWR Levee Log, 2002 (HLM 24.86), listed as a 30-inch corrugated metal pipe (CMP). USACE San Joaquin O&M Manual, Unit 601 Part 1 (SJR601.1), 1967, Revised 25 May 2011, (HLM 24.87), listed as a 30-inch CMP]

Levee crown.

LS view: Slope and headwall from toe.

LS view: Inside pipe inlet at toe.

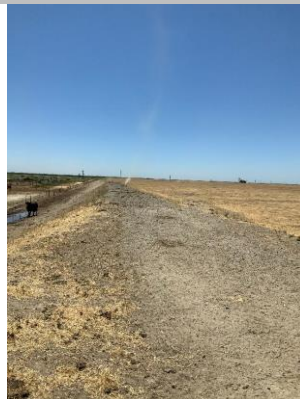
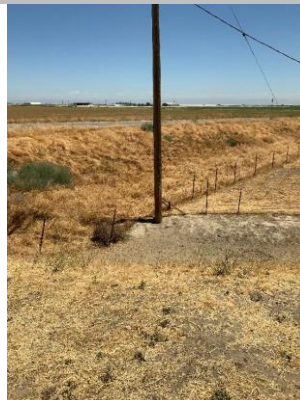
Comment Code						
Inspector Comment						
DS_ID:19802 FS_ID:70192 EP_NO: 12873 Repair Type: Non-Urgent EVAL Issue: Abandoned encroachment Crossing Status: Found UCIP Comments: 06/23/2021 The record remains Non-Urgent. Appears abandoned, did not find valve or electrical panel on LS. Confirm with owner on the status of this crossing. The UCIP inspection was completed with GEI staff, P. Espinoza. (H. Dunn – GEI) 03/25/2014 Clear soil from siphon breaker and install a protective riser. (W. Wylie - DWR UCIP) FIELD_STRUCT_DESC: 16-inch coated steel irrigation discharge pipe through the levee, 2 feet below the crown. Slant pump at the channel on the waterside (WS) toe. Siphon breaker on the WS shoulder. Gate valve on the landside (LS) toe. A preexisting ditch runs from the WS toe to the channel. Riprap placed around the intake. 2-inch polyvinyl chloride (PVC) electrical conduit at the same location. (Plans to install a pump with a discharge pipe through the levee authorized under Permit No. 12873, 1980 - Bowles Farming Company). [Additional Reference(s): DWR Levee Log, 2002 (HLM 24.88), listed as a 16-inch pipe] FS Date: 6/23/2021

Levee crown.

LS view: Toe from crown, no valve visible.

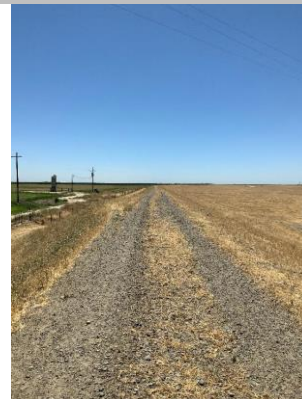
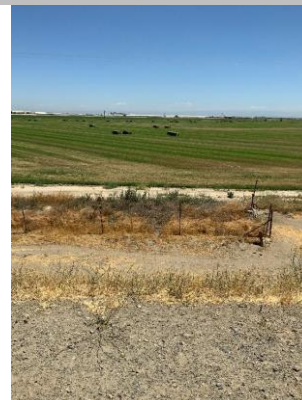
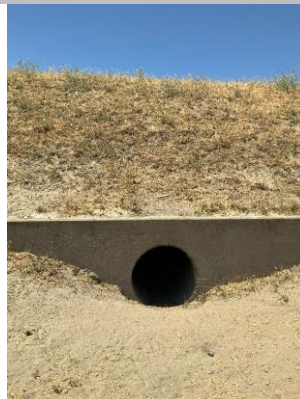
Comment Code					
Inspector Comment					
DS_ID:19803 FS_ID:70106 EP_NO: N/A Repair Type: Non-Urgent EVAL Issue: Unauthorized Encroachment, installed decades prior Crossing Status: Found UCIP Comments: 06/23/2021 The record remains Non-Urgent. DWR DMP internal inspection has not found pipe integrity issues. LOF of crossing is less or equal to 4.0. Recommend next video inspection in 5 years. No permit was found authorizing this encroachment. CVFPB will need to review crossing to determine owner. The UCIP inspection was completed with GEI staff, P. Espinoza. (H. Dunn – GEI) 03/25/2014 Flapgate propped open during flood season. (W. Wylie - DWR UCIP) FIELD_STRUCT_DESC: 30-inch corrugated metal gravity drainage pipe through the levee, 11.3 feet below the crown. Flap gate on the waterside (WS) end. Concrete headwall on the landside (LS) end. Concrete U-shaped headwall on the WS end. [Additional Reference(s): DWR Levee Log, 2002 (HLM 25.14), listed as a 30-inch corrugated metal pipe (CMP). USACE San Joaquin O&M Manual, Unit 601 Part 1 (SJR601.1), 1967, Revised 25 May 2011, (recorded incorrectly as HLM 25.43 correct HLM 25.13), listed as a 30-inch CMP] FS Date: 6/23/2021

Levee crown.

LS view: Toe from crown.

LS view: Slope and headwall from toe.

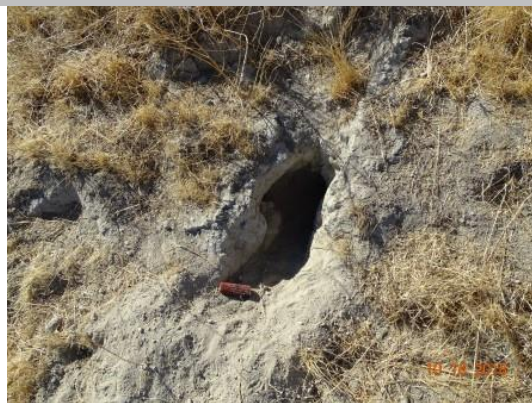
Photo 1 of 1 : FA\_2021\_NA0010\_123\_9\_20210830\_00007.jpg

LM Start	25.28	Rating **	M	Issue No.	9
LM End	25.35	Issue Type +	Ma	Location *	LS
Category	Earthen Levee			GPS Latitude/Longitude	
				Start	End
Item	Animal Control			37.051076 °	37.050349 °
				-120.492153 °	-120.491269 °
DWR ID	DWR_NA0010_05_s_2012_9				
Comment Code					
A1 : Exterminate rodents and backfill and compact or grout burrows.					
Inspector Comment					
Several rodent holes are noted along this section.

View of representative rodent burrow. (Fall 2018)

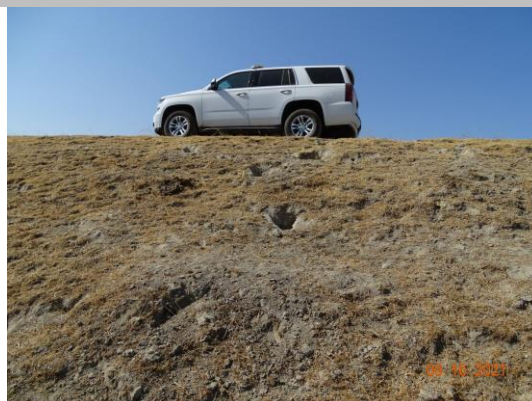
Photo 1 of 1 : FA\_2021\_NA0010\_123\_167\_20210929\_00340.jpg

LM Start	25.46	Rating **	M	Issue No.	167
LM End	25.52	Issue Type +	Ma	Location *	LS
Category	Earthen Levee			GPS Latitude/Longitude	
				Start	End
Item	Animal Control			37.049218 °	37.048502 °
				-120.489883 °	-120.489257 °
DWR ID	DWR_NA0010_05_f_2021_167				
Comment Code					
A3 : No rodents visible, but rodent burrows visible; need to backfill and compact or grout burrows.					
Inspector Comment

Multiple rodent holes observed on the landside slope. (Fall 2021)

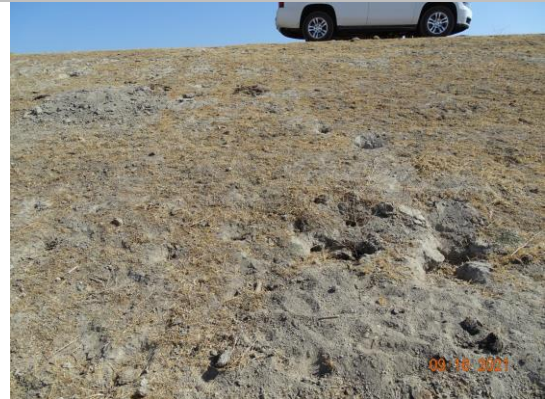
Photo 1 of 1 : FA\_2021\_NA0010\_123\_168\_20210929\_00341.jpg

LM Start	25.46	Rating **	M	Issue No.	168
LM End	25.46	Issue Type +	Ma	Location *	WS
Category	Earthen Levee			GPS Latitude/Longitude	
				Start	End
Item	Animal Control			37.049217 °	37.049217 °
				-120.489881 °	-120.489881 °
DWR ID	DWR_NA0010_05_f_2021_168				
Comment Code					
A3 : No rodents visible, but rodent burrows visible; need to backfill and compact or grout burrows.					
Inspector Comment

View of rodent burrows on the waterside slope. (Fall 2021)

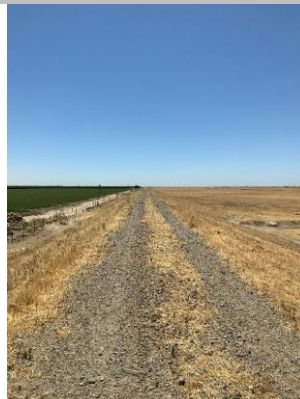
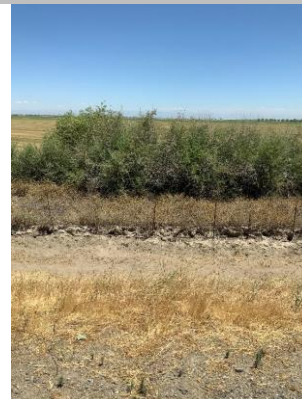
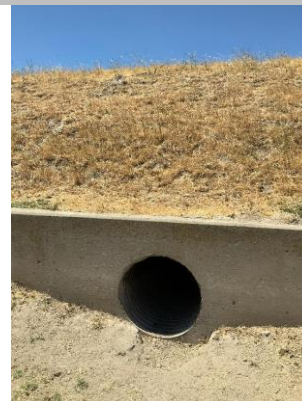
Comment Code						
Inspector Comment						
DS_ID:19804 FS_ID:70147 EP_NO: N/A Repair Type: Urgent EVAL Issue: Pipe Integrity Crossing Status: Found UCIP Comments: 06/23/2021 The record has been upgraded from Non-Urgent to Urgent. DWR DMP internal inspection has found pipe integrity issues. LOF of crossing is greater than or equal to 5 and less than 6. Crossing will be monitored until funding becomes available to address the issues. No permit was found authorizing this encroachment. CVFPB will need to review crossing to determine owner. The UCIP inspection was completed with GEI staff, P. Espinoza. (H. Dunn – GEI)03/25/2014 Dense vegetation limits the inspector's visibility to identify signs of pipe failure (leaks) along the landward slope. Recommend removing vegetation along pipe alignment to conduct proper inspection of structure. Sediment buildup in pipe visible from landward side--recommend contacting owner to clear pipe. (W. Wylie - DWR UCIP) FIELD_STRUCT_DESC: 30-inch corrugated metal gravity drainage pipe through the levee, 12 feet below the crown. Flap gate on the waterside (WS) end. Concrete headwall on the landside (LS) end. Concrete U-shaped headwall on the WS end. [Additional Reference(s): DWR Levee Log, 2002 (HLM 25.51), listed as a 30-inch corrugated metal pipe (CMP). USACE San Joaquin O&M Manual, Unit 601 Part 1 (SJR601.1), 1967, Revised 25 May 2011, (HLM 25.51), listed as a 30-inch CMP] FS Date: 6/23/2021

Levee crown.

LS view: Toe from crown.

LS view: Slope and headwall from toe.

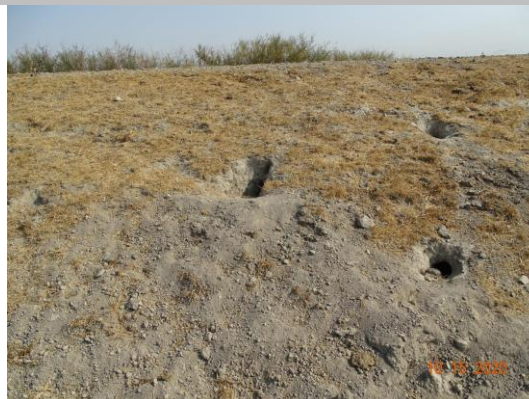
Photo 1 of 1 : FA\_2021\_NA0010\_123\_124\_20210830\_00025.jpg

LM Start	25.61	Rating **	M	Issue No.	124
LM End	25.61	Issue Type +	Ma	Location *	WS
Category	Earthen Levee			GPS Latitude/Longitude	
				Start	End
Item	Animal Control			37.047416 °	37.047416 °
				-120.488411 °	-120.488411 °
DWR ID	DWR_NA0010_05_f_2017_124				
Comment Code					
A1 : Exterminate rodents and backfill and compact or grout burrows.					
Inspector Comment

Looking east at the waterside slope. (Fall 2020)

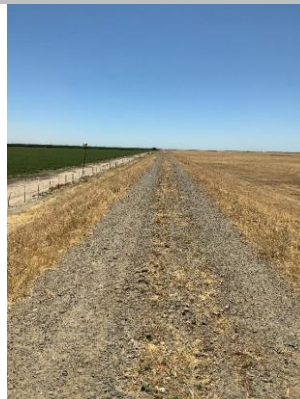
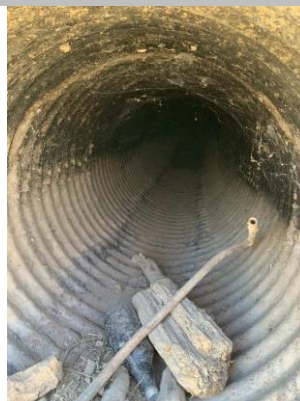
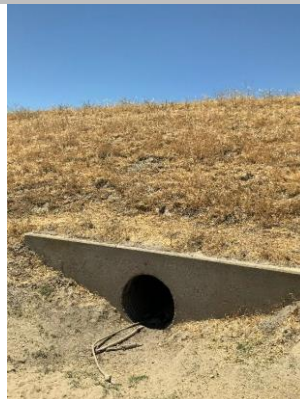
DS\_ID:19805  
FS\_ID:70193  
EP\_NO: N/A  
Repair Type: Urgent  
EVAL Issue: Pipe Integrity  
Crossing Status: Found  
UCIP Comments: 06/23/2021 The record has been upgraded from Non-Urgent to Urgent. DWR DMP internal inspection has found pipe integrity issues. LOF of crossing is greater than or equal to 5 and less than 6. Crossing will be monitored until funding becomes available to address the issues. No permit was found authorizing this encroachment. CVFPB will need to review crossing to determine owner. The UCIP inspection was completed with GEI staff, P. Espinoza. (H. Dunn – GEI)03/25/2014 Sediment buildup in pipe visible from landward side-- recommend contacting owner to clear pipe. (W. Wylie - DWR UCIP) FIELD\_STRUCT\_DESC: 30-inch corrugated metal gravity drainage pipe through the levee, 12.1 feet below the crown. Flap gate on the waterside (WS) end. Concrete headwall on the landside (LS) end. Concrete U-shaped headwall on the WS end. [Additional Reference(s): DWR Levee Log, 2002 (HLM 25.53), listed as a 30-inch corrugated metal pipe (CMP). USACE San Joaquin O&M Manual, Unit 601 Part 1 (SJR601.1), 1967, Revised 25 May 2011, (HLM 25.53), listed as a 30-inch CMP]

Levee crown.

LS view: Inside pipe inlet at toe.

LS view: Slope and headwall from toe.

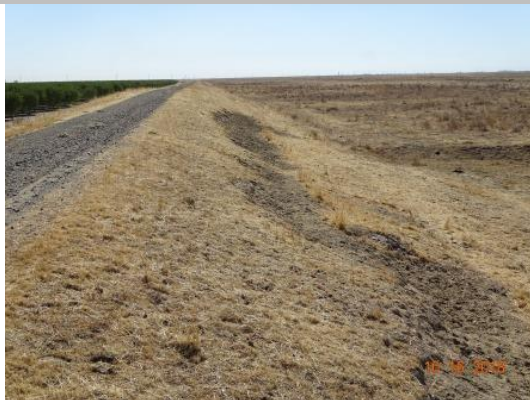
Photo 1 of 1 : FA\_2021\_NA0010\_123\_161\_20210830\_00048.jpg

LM Start	26.17	Rating **	M	Issue No.	161
LM End	26.21	Issue Type +	Ma	Location *	WS
Category	Earthen Levee			GPS Latitude/Longitude	
				Start	End
Item	Animal Control			37.040434 °	37.040043 °
				-120.483086 °	-120.482795 °
DWR ID	DWR_NA0010_05_f _ 2018_161				
Comment Code					
A2 : Repair the levee slope damaged by livestock and prevent large animal access.					
Inspector Comment					
Waterside slope damage is caused by livestock foot traffic.

Slope damage on waterside. (Fall 2018)

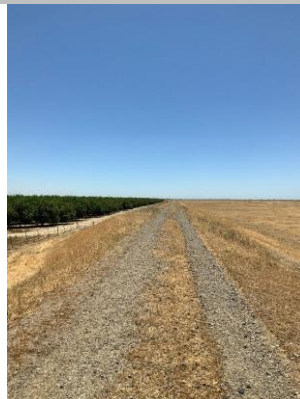
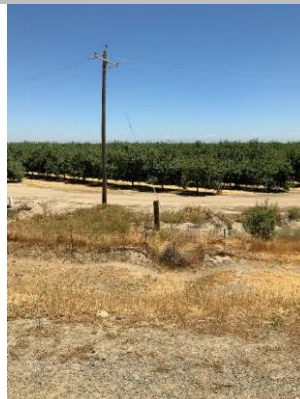
DS\_ID:19806  
FS\_ID:70149  
EP\_NO: N/A  
Repair Type: Urgent  
EVAL Issue: Pipe Integrity  
Crossing Status: Found  
UCIP Comments: 06/23/2021 The record has been upgraded from Non-Urgent to Urgent. DWR DMP internal inspection has found pipe integrity issues. LOF of crossing is greater than or equal to 5 and less than 6. Crossing will be monitored until funding becomes available to address the issues. No permit was found authorizing this encroachment. CVFPB will need to review crossing to determine owner. The UCIP inspection was completed with GEI staff, P. Espinoza. (H. Dunn – GEI)03/25/2014 Sediment buildup in pipe visible from landward side-- recommend contacting owner to clear pipe. (W. Wylie - DWR UCIP) FIELD\_STRUCT\_DESC: 24-inch corrugated metal gravity drainage pipe through the levee, 10 feet below the crown. Flap gate on the waterside (WS) end. Concrete headwall on the landside (LS) end. Concrete U-shaped headwall on the WS end. [Additional Reference(s): DWR Levee Log, 2002 (HLM 26.10), listed as a 24-inch corrugated metal pipe (CMP). USACE San Joaquin O&M Manual, Unit 601 Part 1 (SJR601.1), 1967, Revised 25 May 2011, (HLM 26.11), listed as a 24-inch CMP]

Levee crown.

LS view: Toe from crown.

LS view: Slope and headwall from toe.

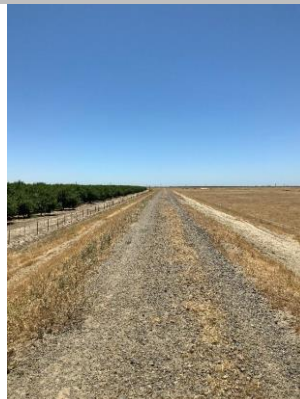
Photo 1 of 3 : UCIP\_FA\_2021\_70150\_104455.jpg

Comment Code						
Inspector Comment						
DS_ID:19807 FS_ID:70150 EP_NO: N/A Repair Type: Urgent EVAL Issue: Pipe Integrity Crossing Status: Found UCIP Comments: 06/23/2021 The record has been upgraded from No Action Needed to Urgent. DWR DMP internal inspection has found pipe integrity issues. LOF of crossing is greater than or equal to 5 and less than 6. Crossing will be monitored until funding becomes available to address the issues. No permit was found authorizing this encroachment. CVFPB will need to review crossing to determine owner. The UCIP inspection was completed with GEI staff, P. Espinoza. (H. Dunn – GEI) FIELD_STRUCT_DESC: 36-inch corrugated metal gravity drainage pipe through the levee, 13 feet below the crown. Flap gate on the waterside (WS) end. Concrete headwall on the landside (LS) end. Concrete U-shaped headwall on the WS end. [Additional Reference(s): DWR Levee Log, 2002 (HLM 26.29), listed as a 36-inch corrugated metal pipe (CMP). USACE San Joaquin O&M Manual, Unit 601 Part 1 (SJR601.1), 1967, Revised 25 May 2011, (HLM 26.29), listed as a 36-inch CMP] FS Date: 6/23/2021

Levee crown.

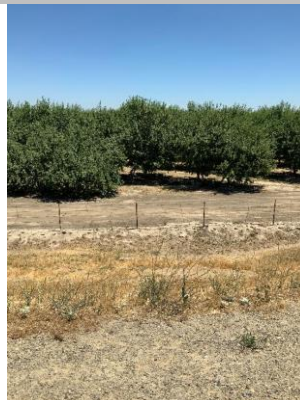
Photo 2 of 3 : UCIP\_FA\_2021\_70150\_104456.jpg

LS view: Toe from crown.

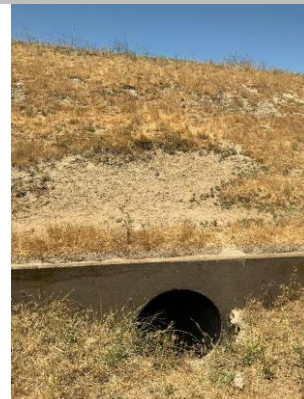
Photo 3 of 3 : UCIP\_FA\_2021\_70150\_104459.jpg

LS view: Slope and headwall from toe.

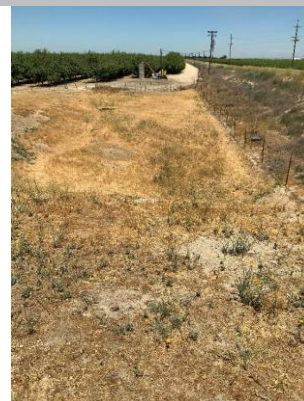
Photo 1 of 3 : UCIP\_FA\_2021\_70151\_104461.jpg

DS\_ID:19808  
 FS\_ID:70151  
 EP\_NO: N/A  
 Repair Type: Urgent  
 EVAL Issue: Pipe Integrity  
 Crossing Status: Found  
 UCIP Comments: 06/23/2021 The record has been upgraded from Non-Urgent to Urgent. LOF of crossing is greater than or equal to 5 and less than 6. Crossing will be monitored until funding becomes available to address issues. No permit was found authorizing this encroachment. CVFPB will need to review crossing to determine owner. The UCIP inspection was completed with GEI staff, P. Espinoza. (H. Dunn – GEI)03/25/2014 Pipe has heavy silt buildup visible from landward side--recommend contacting owner to clear pipe. (W. Wylie - DWR UCIP)  
 FIELD\_STRUCT\_DESC: 24-inch corrugated metal gravity drainage pipe through the levee, 11.4 feet below the crown. Flap gate on the waterside (WS) end. Concrete headwall on the landside (LS) end. Concrete U-shaped headwall on the WS end. [Additional Reference(s): DWR Levee Log, 2002 (HLM 26.85), listed as a 24-inch corrugated metal pipe (CMP). USACE San Joaquin O&M Manual, Unit 601 Part 1 (SJR601.1), 1967, Revised 25 May 2011, (HLM 26.85), listed as a 24-inch CMP]

LS view: Toe from crown.

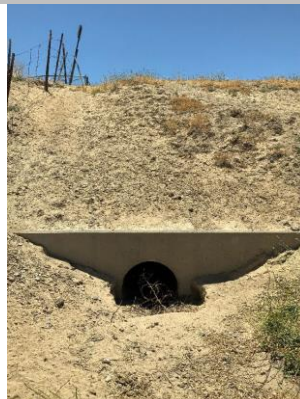
Photo 2 of 3 : UCIP\_FA\_2021\_70151\_104463.jpg

LS view: Slope and headwall from toe.

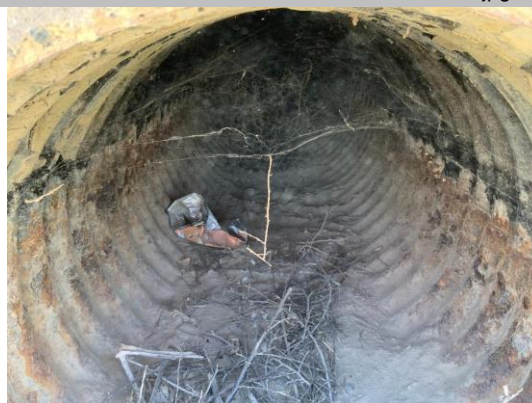
Photo 3 of 3 : UCIP\_FA\_2021\_70151\_104464.jpg

LS view: Inside of pipe inlet at toe.

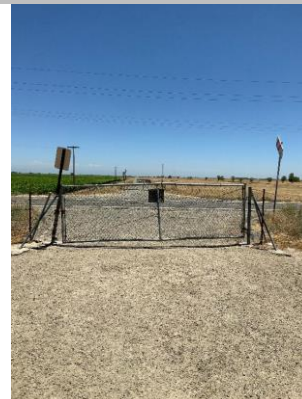
Photo 1 of 3 : UCIP\_FA\_2021\_70105\_104467.jpg

Comment Code						
Inspector Comment						
DS_ID:24851 FS_ID:70105 EP_NO: 16002 Repair Type: Non-Urgent EVAL Issue: Safety Issue Crossing Status: Found UCIP Comments: 06/23/2021 The record has been upgraded from No Action Needed to Non-Urgent. As a safety measure, need to coordinate with owner to determine status of line and to obtain maintenance and inspection records to confirm integrity of line through the levee. No LS markers but one on WS. The UCIP inspection was completed with GEI staff, P. Espinoza. (H. Dunn – GEI) FIELD_STRUCT_DESC: 8-inch steel natural gas pipeline through the levee, 1.5 feet below the crown. Gas line marker on the waterside (WS) shoulder. This crossing was field discovered. (Plans to install an 8-inch natural gas pipeline under both levees of the Chowchilla Canal Bypass and the San Joaquin River authorized under Permit No. 16002, 1993 - Union Oil Company of California). FS Date: 6/23/2021

Levee crown.

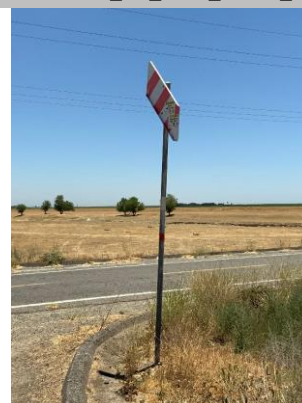
Photo 2 of 3 : UCIP\_FA\_2021\_70105\_104468.jpg

WS view: Marker visible off the crown.

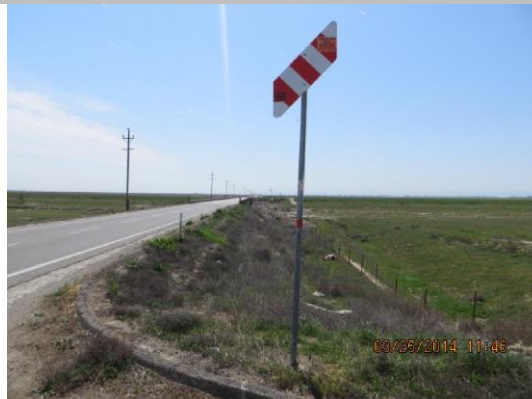
Photo 3 of 3 : UCIP\_FA\_2021\_70105\_71485.jpg

Gasline marker on WS shoulder.

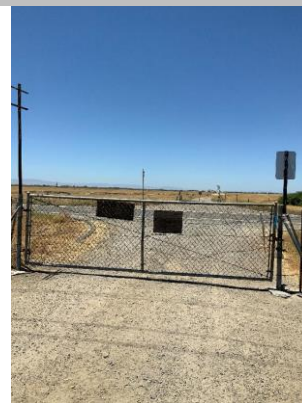
Photo 1 of 3 : UCIP\_FA\_2021\_70152\_104358.jpg

DS\_ID:19748  
 FS\_ID:70152  
 EP\_NO: N/A  
 Repair Type: Urgent  
 EVAL Issue: Pipe Integrity  
 Crossing Status: Found  
 UCIP Comments: 06/23/2021 Record has been upgraded from Non-Urgent to Urgent. DWR DMP internal inspection has found pipe integrity issues. LOF of crossing is greater than or equal to 5 and less than 6. Crossing will be monitored until funding becomes available to address the issues. Limited inspection of LS inlet due to dirt and tumbleweeds, recommend removal. Unidentified PVC pipe installed at mouth of inlet pipe on LS. No permit was found authorizing this encroachment. CVFPB will need to review crossing to determine owner. The UCIP inspection was completed with GEI staff, H.Dunn. (P.Espinoza – GEI)03/25/2014 Tumble weed buildup at inlet may create blockage and should be removed. (W. Wylie - DWR UCIP)  
 FIELD\_STRUCT\_DESC: 24-inch corrugated metal gravity drainage pipe through the levee, 11.3 feet below the crown. Flap gate on the waterside (WS) end. Concrete headwall on the landside (LS) end. Concrete U-shaped headwall on the WS end. [Additional Reference(s): DWR Levee Log, 2002 (HLM 26.87), listed as a 24-inch corrugated metal pipe (CMP). USACE San Joaquin O&M Manual, Unit 601 Part 1 (SJR601.1), 1967, Revised 25 May 2011, (HLM 26.87), listed as a 24-inch CMP]

View from levee crown.

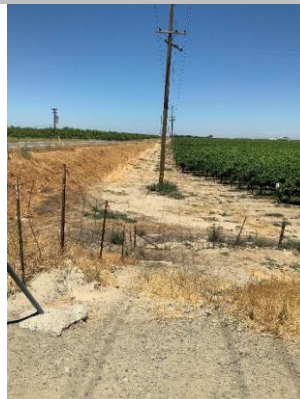
Photo 2 of 3 : UCIP\_FA\_2021\_70152\_104359.jpg

LS view from crown.

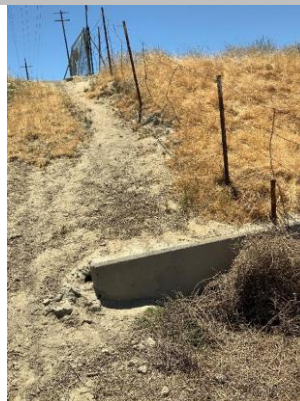
Photo 3 of 3 : UCIP\_FA\_2021\_70152\_104361.jpg

LS view from toe: concrete headwall at inlet

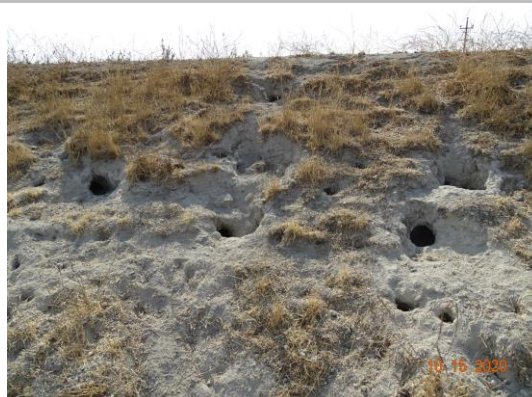
Photo 1 of 1 : FA\_2021\_NA0010\_123\_162\_20210830\_00049.jpg

LM Start	26.99	Rating **	U	Issue No.	162
LM End	27.04	Issue Type +	Ma	Location *	LS
Category	Earthen Levee			GPS Latitude/Longitude	
				Start	End
Item	Animal Control			37.032651 °	37.032659 °
				-120.473205 °	-120.472190 °
DWR ID	DWR_NA0010_05_f_2018_162				
Comment Code					
A1 : Exterminate rodents and backfill and compact or grout burrows.					
Inspector Comment					
Several rodent burrows with large quantities of material displaced noted in this section.

Several rodent burrows noted in this section of the levee. (Fall 2020)

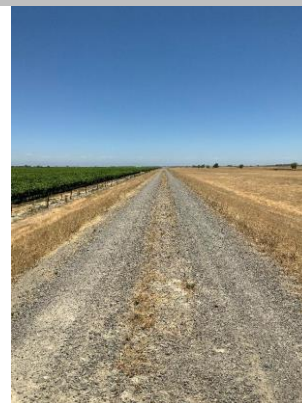
Photo 1 of 3 : UCIP\_FA\_2021\_70153\_104352.jpg

Comment Code						
Inspector Comment						
DS_ID:19749 FS_ID:70153 EP_NO: N/A Repair Type: Urgent EVAL Issue: Pipe Integrity Crossing Status: Found UCIP Comments: 06/23/2021 The record has been upgraded from No Action Needed to Urgent. DWR DMP internal inspection has found pipe integrity issues. LOF of crossing is greater than or equal to 5 and less than 6. Crossing will be monitored until funding becomes available to address the issues. No permit was found authorizing this encroachment. CVFPB will need to review crossing to determine owner. The UCIP inspection was completed with GEI staff, H.Dunn. (P.Espinoza – GEI) FIELD_STRUCT_DESC: 36-inch corrugated metal gravity drainage pipe through the levee, 12 feet below the crown. Flap gate on the waterside (WS) end. Concrete headwall on the landside (LS) end. Concrete U-shaped headwall on the WS end. [Additional Reference(s): DWR Levee Log, 2002 (HLM 27.21), listed as a 36-inch corrugated metal pipe (CMP). USACE San Joaquin O&M Manual, Unit 601 Part 1 (SJR601.1), 1967, Revised 25 May 2011, (HLM 27.22), listed as a 36-inch CMP] FS Date: 6/23/2021

View from levee crown.

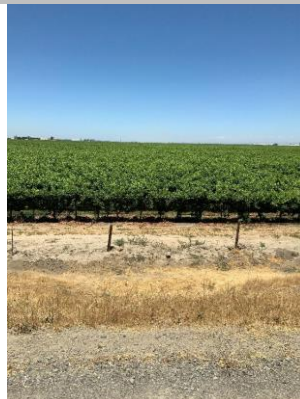
Photo 2 of 3 : UCIP\_FA\_2021\_70153\_104354.jpg

LS view from crown.

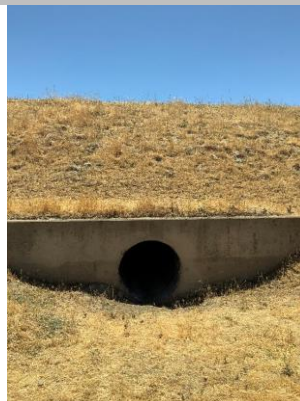
Photo 3 of 3 : UCIP\_FA\_2021\_70153\_104356.jpg

LS view from toe: concrete headwall at inlet.
