## Flood Control Project Maintenance Levee Inspections

### Fall 2021 Levee Maintenance Deficiency Summary Report

#### San Joaquin River Basin

NA0010 Lower San Joaquin Levee District	Overall LMA Rating	Total LMA Miles							
	U	191.27							
Rated Item	Maintenance Deficiency				Enforcement		Design & System Obsolescence		
	M Miles	U Miles	M + 4U Miles	Threshold %	M Miles	U Miles	M Miles	U Miles	
<i>Earthen Levee</i>									
Vegetation	47.00	9.57	85.28	44.59%					
Trim / Thin Trees	0.10		0.10	0.05%					
Encroachments	0.23	0.02	0.31	0.16%	9.29	0.59			
Animal Control	7.67	2.19	16.43	8.59%					
Slope Stability	0.05	0.01	0.09	0.05%					
Erosion / Bank Caving	0.13	0.81	3.37	1.76%					
Crown Surface / Depressions / Rutting	0.01		0.01	0.01%					
Repair Gates	0.02	0.02	0.10	0.05%					
<i>Rivers, Channels &amp; Designated Floodways</i>									
Encroachments					0.01	0.01			
<i>Supplemental</i>									
DWR Erosion Survey	0.12	0.17	0.80	0.42%					
DWR UCIP Field Study					1.29	0.05			
DWR UCIP LMA Responsibility									
<i>LMA Totals:</i>	55.33	12.79	106.49	55.67%	10.59	0.65	0.00	0.00

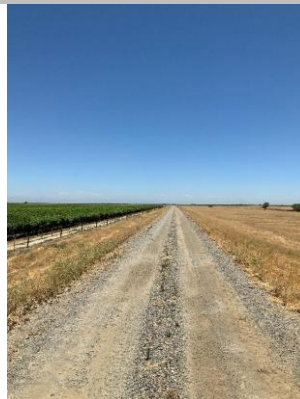
Photo 1 of 3 : UCIP\_FA\_2021\_70154\_104347.jpg

Comment Code						
Inspector Comment						
DS_ID:19750 FS_ID:70154 EP_NO: N/A Repair Type: Non-Urgent EVAL Issue: Maintenance Compliance Issue Crossing Status: Found UCIP Comments: 06/23/2021 The record remains Non-Urgent. DWR DMP internal inspection has not found pipe integrity issues. LOF of crossing is less or equal to 4.0. Recommend next video inspection in 5 years. Sediment buildup in inlet pipe; recommend removal. No permit was found authorizing this encroachment. CVFPB will need to review crossing to determine owner. The UCIP inspection was completed with GEI staff, P. Espinoza. (H. Dunn – GEI) 03/25/2014 Animal Burrowing activity at LS toe may undermine headwall. (W. Wylie - DWR UCIP) FIELD_STRUCT_DESC: 24-inch corrugated metal gravity drainage pipe through the levee, 10.8 feet below the crown. Flap gate on the waterside (WS) end. Concrete headwall on the landside (LS) end. Concrete U-shaped headwall on the WS end. [Additional Reference(s): DWR Levee Log, 2002 (HLM 28.17), listed as a 24-inch corrugated metal pipe (CMP). USACE San Joaquin O&M Manual, Unit 601 Part 1 (SJR601.1), 1967, Revised 25 May 2011, (HLM 28.17), listed as a 24-inch CMP] FS Date: 6/23/2021

View from levee crown.

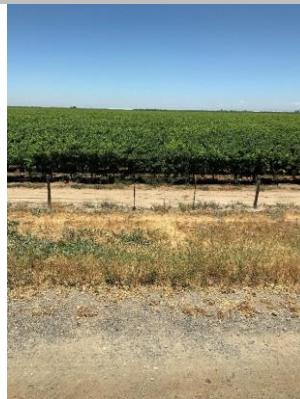
Photo 2 of 3 : UCIP\_FA\_2021\_70154\_104346.jpg

LS view from crown.

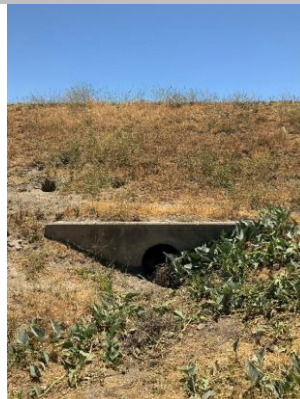
Photo 3 of 3 : UCIP\_FA\_2021\_70154\_104350.jpg

LS view from toe: concrete headwall at inlet.

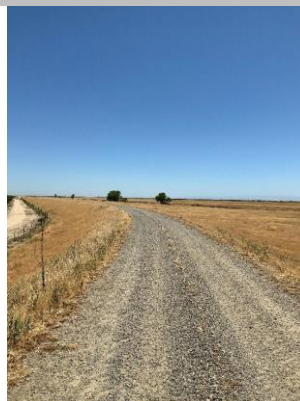
Photo 1 of 3 : UCIP\_FA\_2021\_70155\_104318.jpg

DS\_ID:19751  
 FS\_ID:70155  
 EP\_NO: N/A  
 Repair Type: Urgent  
 EVAL Issue: Pipe Integrity  
 Crossing Status: Found  
 UCIP Comments: 06/23/2021 The record has been upgraded from No Action Needed to Urgent. DWR DMP internal inspection has found pipe integrity issues. LOF of crossing is between 5 and 6. Crossing will be monitored until funding becomes available to address the issues. Sediment build up in LS pipe inlet; recommend removal. No permit was found authorizing this encroachment. CVFPB will need to review crossing to determine owner. The UCIP inspection was completed with GEI staff, H.Dunn. (P.Espinoza – GEI)  
 FIELD\_STRUCT\_DESC: 30-inch corrugated metal gravity drainage pipe through the levee, 9.8 feet below the crown. Flap gate on the waterside (WS) end. Concrete headwall on the landside (LS) end. Concrete U-shaped headwall on the WS end. [Additional Reference(s): DWR Levee Log, 2002 (HLM 28.69), listed as a 30-inch corrugated metal pipe (CMP). USACE San Joaquin O&M Manual, Unit 601 Part 1 (SJR601.1), 1967, Revised 25 May 2011, (HLM 28.69), listed as a 30-inch CMP]

View from levee crown.

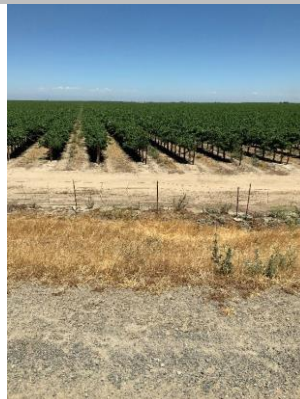
Photo 2 of 3 : UCIP\_FA\_2021\_70155\_104319.jpg

LS view from crown.

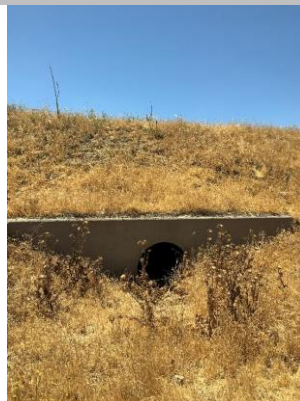
Photo 3 of 3 : UCIP\_FA\_2021\_70155\_104321.jpg

LS view from toe: concrete headwall at inlet.

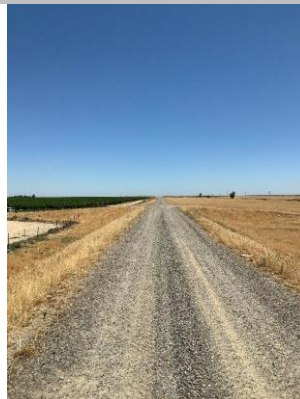
Photo 1 of 3 : UCIP\_FA\_2021\_70038\_104313.jpg

Comment Code						
Inspector Comment						
DS_ID:19752 FS_ID:70038 EP_NO: N/A Repair Type: Non-Urgent EVAL Issue: Limited Inspection/No UCIP Evaluation Crossing Status: Found UCIP Comments: 06/23/2021 The record remains Non-Urgent. Limited inspection of LS due to accessibility issues; barbed wire fence. No permit was found authorizing this encroachment. CVFPB will need to review crossing to determine owner. The UCIP inspection was completed with GEI staff, H.Dunn. (P.Espinoza – GEI) 7/20/2016 same as previous inspection. Crossing has been downgraded from Urgent to Non-Urgent slide gate is on LS. Pipe is buried through WS. Need to coordinate with owner to determine permit used to authorized sleeved pipe. (O. Magana - DWR UCIP)3/27/2014 Slide gate will not close due to 24-inch PVC pipe sleeved through pipe. Also slide gate rails rusted beyond use. (W. Wylie - DWR UCIP) FIELD_STRUCT_DESC: [Rodunder Siphon Structure] 48-inch reinforced concrete irrigation siphon pipe through the levee, 12.1 feet below the crown. Concrete U-shaped headwall on inlet structure on the landside (LS) end. Slide gate mounted on concrete headwall on the LS. 36-inch corrugated metal pipe (CMP) riser with a slide gate on the LS, 8 feet upstream from the siphon. 24-inch pipe from this unit enters the siphon behind the inlet structure. [Additional Reference(s): DWR Levee Log, 2002 (HLM 28.95), listed as a 48-inch reinforced concrete pipe (RCP). USACE San Joaquin O&M Manual, Unit 601 Part 1 (SJR601.1), 1967, Revised 25 May 2011, (HLM 28.95), listed as a 48-inch RCP referenced as Rodunder Siphon] FS Date: 6/23/2021 9:55:42 AM

View from levee crown.

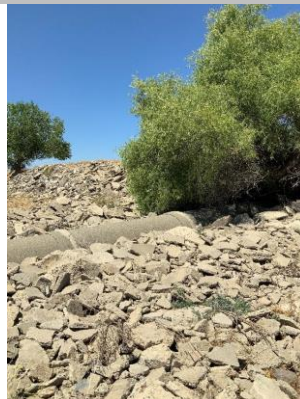
Photo 2 of 3 : UCIP\_FA\_2021\_70038\_104315.jpg

View of concrete crossing through channel.

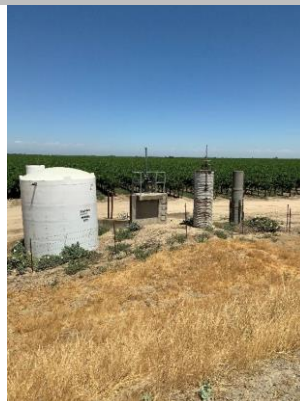
Photo 3 of 3 : UCIP\_FA\_2021\_70038\_104314.jpg

LS view from crown. Slide gate mounted to concrete headwall.

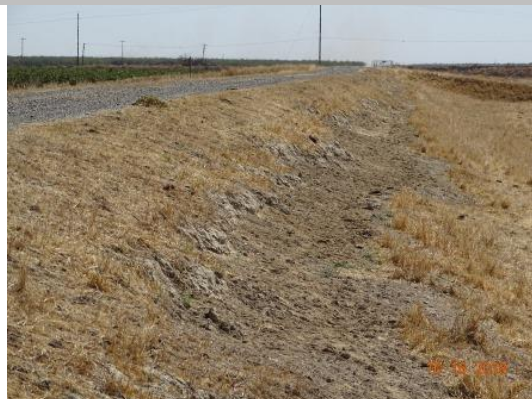
Photo 1 of 1 : FA\_2021\_NA0010\_123\_164\_20210830\_00050.jpg

LM Start	29.43	Rating **	M	Issue No.	164
LM End	29.56	Issue Type +	Ma	Location *	WS
Category	Earthen Levee			GPS Latitude/Longitude	
				Start	End
Item	Animal Control			37.023481 °	37.021794 °
				-120.435960 °	-120.434769 °
DWR ID	DWR_NA0010_05_f_2018_164				
Comment Code					
A2 : Repair the levee slope damaged by livestock and prevent large animal access.					
Inspector Comment					
There is slope damage on waterside from livestock traffic.

Slope damage from animal traffic. (Fall 2018)

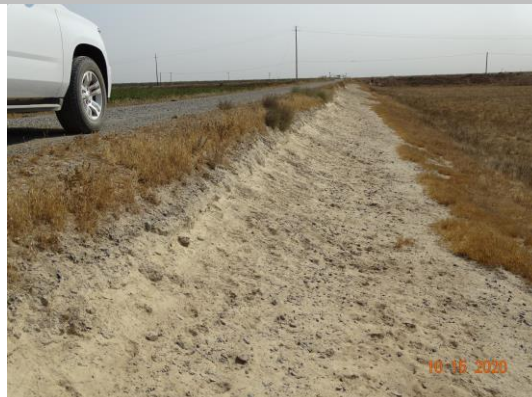
Photo 1 of 1 : FA\_2021\_NA0010\_123\_171\_20210830\_00051.jpg

LM Start	29.58	Rating **	M	Issue No.	171
LM End	29.80	Issue Type +	Ma	Location *	WS
Category	Earthen Levee			GPS Latitude/Longitude	
				Start	End
Item	Animal Control			37.021534 °	37.018712 °
				-120.434592 °	-120.432682 °
DWR ID	DWR_NA0010_05_s_2014_171				
Comment Code					
A2 : Repair the levee slope damaged by livestock and prevent large animal access.					
Inspector Comment					
There is waterside erosion caused by livestock.

Looking south at livestock erosion on the waterside slope. (Fall 2020)

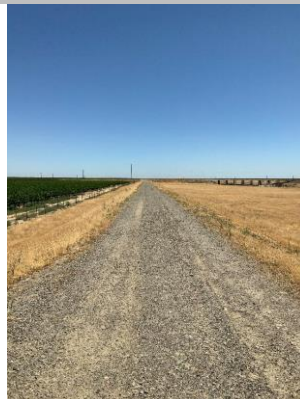
Photo 1 of 3 : UCIP\_FA\_2021\_70156\_104307.jpg

Comment Code					
Inspector Comment					
DS_ID:19753 FS_ID:70156 EP_NO: N/A Repair Type: Non-Urgent EVAL Issue: Pipe Damage Crossing Status: Found UCIP Comments: 06/23/2021 The record remains Non-Urgent. DWR DMP internal inspection has found pipe integrity issues. LOF of crossing is between 4.1 and 5. Crossing will be monitored until funding becomes available for rehabilitation. No permit was found authorizing this encroachment. CVFPB will need to review crossing to determine owner. The UCIP inspection was completed with GEI staff, H.Dunn. (P.Espinoza – GEI) 03/27/2014 Dense vegetation limits the inspector's visibility to identify signs of pipe failure (leaks) along the landward slope. Recommend removing vegetation along pipe alignment to conduct proper inspection of structure. Sediment buildup in pipe visible from landward side--recommend contacting owner to clear pipe. (W. Wylie - DWR UCIP) FIELD_STRUCT_DESC: 36-inch corrugated metal gravity drainage pipe through the levee, 10.2 feet below the crown. Flap gate on the waterside (WS) end. Concrete headwall on the landside (LS) end. Concrete U-shaped headwall on the WS end. [Additional Reference(s): DWR Levee Log, 2002 (HLM 29.49), listed as a 36-inch corrugated metal pipe (CMP). USACE San Joaquin O&M Manual, Unit 601 Part 1 (SJR601.1), 1967, Revised 25 May 2011, (HLM 29.49), listed as a 36-inch CMP] FS Date: 6/23/2021

View from levee crown.

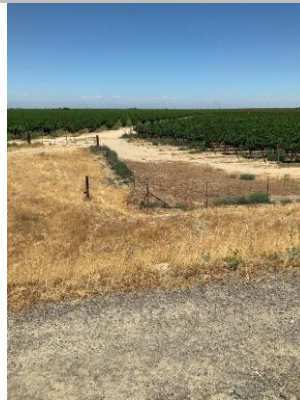
Photo 2 of 3 : UCIP\_FA\_2021\_70156\_104309.jpg

LS view from crown.

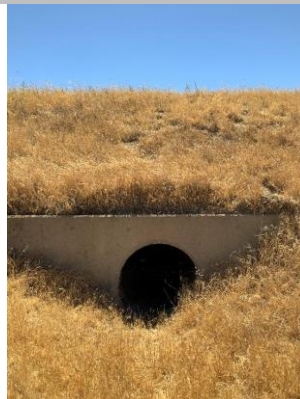
Photo 3 of 3 : UCIP\_FA\_2021\_70156\_104311.jpg

LS view from toe: concrete headwall at inlet.

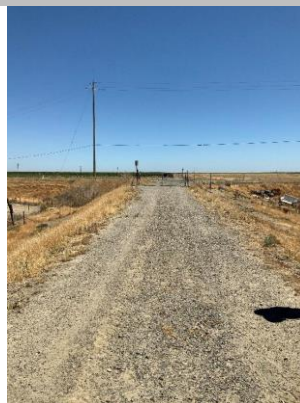
Photo 1 of 3 : UCIP\_FA\_2021\_70194\_104303.jpg

DS\_ID:19754  
 FS\_ID:70194  
 EP\_NO: N/A  
 Repair Type: Non-Urgent  
 EVAL Issue: Unauthorized Encroachment, installed decades prior  
 Crossing Status: Found  
 UCIP Comments: 06/23/2021 The record remains Non-Urgent.  
 Crossing appears to be in good condition. No permit was found authorizing this encroachment. CVFPB will need to review crossing to determine owner. The UCIP inspection was completed with GEI staff, H.Dunn. (P.Espinoza – GEI) 03/27/2014 Dense vegetation limits the inspector's visibility to identify signs of pipe failure (leaks) along the landward slope. Recommend removing vegetation along pipe alignment to conduct proper inspection of structure. (W. Wylie - DWR UCIP)  
 FIELD\_STRUCT\_DESC: 30-inch by 30-inch reinforced concrete box gravity drainage culvert through the levee, 12 feet below the crown. Flap gate on the waterside (WS) end. Concrete headwall on the landside (LS) end. Concrete U-shaped headwall on the WS end.

View from levee crown.

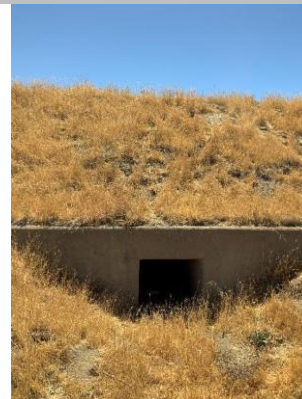
Photo 2 of 3 : UCIP\_FA\_2021\_70194\_104305.jpg

LS view from toe: concrete headwall at inlet.

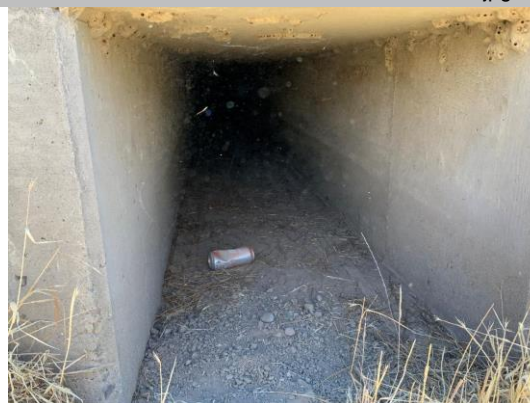
Photo 3 of 3 : UCIP\_FA\_2021\_70194\_104306.jpg

LS view from toe: inside of inlet.

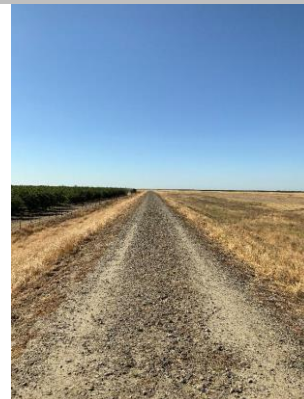
Photo 1 of 3 : UCIP\_FA\_2021\_70158\_104296.jpg

Comment Code						
Inspector Comment						
DS_ID:19696 FS_ID:70158 EP_NO: N/A Repair Type: Non-Urgent EVAL Issue: Limited Inspection/No UCIP Evaluation Crossing Status: Found UCIP Comments: 06/24/2021 The record remains Non-Urgent. Limited inspection of LS due to dense vegetation; recommend removal. No permit was found authorizing this encroachment. CVFPB will need to review crossing to determine owner. The UCIP inspection was completed with GEI staff, H.Dunn. (P.Espinoza – GEI) 03/27/2014 Dense vegetation limits the inspector's visibility to identify signs of pipe failure (leaks) along the landward slope. Recommend removing vegetation along pipe alignment to conduct proper inspection of structure. (W. Wylie - DWR UCIP) FIELD_STRUCT_DESC: 30-inch by 30-inch reinforced concrete box gravity drainage culvert through the levee, 13.1 feet below the crown. Flap gate on the waterside (WS) end. Concrete headwall on the landside (LS) end. Concrete U-shaped headwall on the WS end. [Additional Reference(s): DWR Levee Log, 2002 (HLM 30.04), listed as a 30-inch square reinforced concrete box culvert (RCBC). USACE San Joaquin O&M Manual, Unit 601 Part 1 (SJR601.1), 1967, Revised 25 May 2011, (HLM 30.04), listed as a 2.5-feet by 2.5-feet RCBC] FS Date: 6/24/2021

View from levee crown.

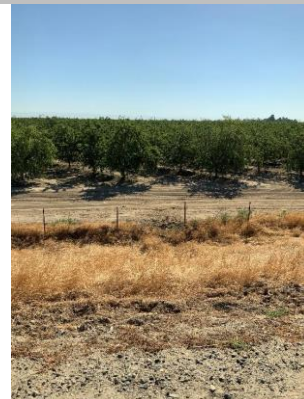
Photo 2 of 3 : UCIP\_FA\_2021\_70158\_104297.jpg

LS view from crown.

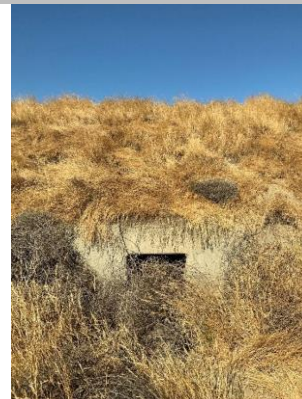
Photo 3 of 3 : UCIP\_FA\_2021\_70158\_104301.jpg

LS view from toe: concrete headwall at inlet.

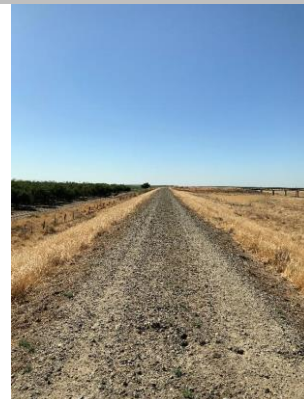
Photo 1 of 3 : UCIP\_FA\_2021\_70159\_104289.jpg

DS\_ID:19697  
FS\_ID:70159  
EP\_NO: N/A  
Repair Type: Non-Urgent  
EVAL Issue: Unauthorized Encroachment, installed decades prior  
Crossing Status: Found  
UCIP Comments: 06/24/2021 The record remains Non-Urgent. Crossing appears to be in good condition. No permit was found authorizing this encroachment. CVFPB will need to review crossing to determine owner. The UCIP inspection was completed with GEI staff, H.Dunn. (P.Espinoza – GEI) 03/27/2014 Some debris buildup at LS toe. Dense vegetation limits the inspector's visibility to identify signs of pipe failure (leaks) along the landward slope. Recommend removing vegetation along pipe alignment to conduct proper inspection of structure. (W. Wylie - DWR UCIP)  
FIELD\_STRUCT\_DESC: 30-inch by 30-inch reinforced concrete box gravity drainage culvert through the levee, 13.3 feet below the crown. Flap gate on the waterside (WS) end. Concrete headwall on the landside (LS) end. Concrete U-shaped headwall on the WS end.

Levee crown.

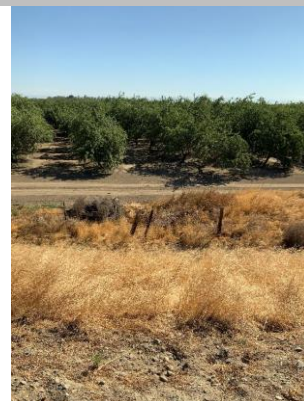
Photo 2 of 3 : UCIP\_FA\_2021\_70159\_104291.jpg

LS view from crown.

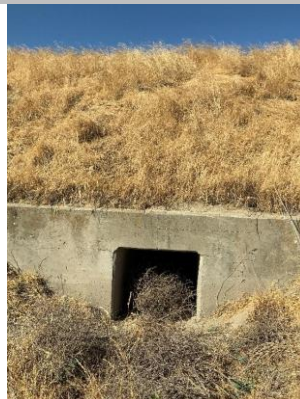
Photo 3 of 3 : UCIP\_FA\_2021\_70159\_104294.jpg

LS view from toe: concrete headwall at inlet.

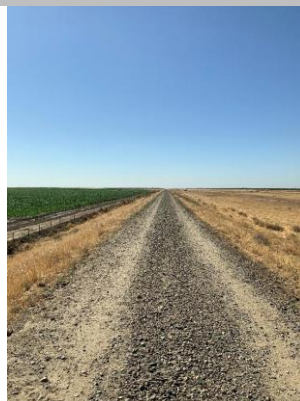
Photo 1 of 3 : UCIP\_FA\_2021\_70160\_104282.jpg

DS\_ID:19698  
FS\_ID:70160  
EP\_NO: N/A  
Repair Type: Non-Urgent  
EVAL Issue: Maintenance Compliance Issue  
Crossing Status: Found  
UCIP Comments: 06/24/2021 The record remains Non-Urgent. Some tumbleweed buildup over WS flapgate and LS inlet, recommend removal. No permit was found authorizing this encroachment. CVFPB will need to review crossing to determine owner. The UCIP inspection was completed with GEI staff, H.Dunn. (P.Espinoza – GEI)

03/27/2014 Excess vegetation buildup at inlet on LS toe. Dense vegetation limits the inspector's visibility to identify signs of pipe failure (leaks) along the landward slope. Recommend removing vegetation along pipe alignment to conduct proper inspection of structure. (W. Wylie - DWR UCIP)

View from levee crown.

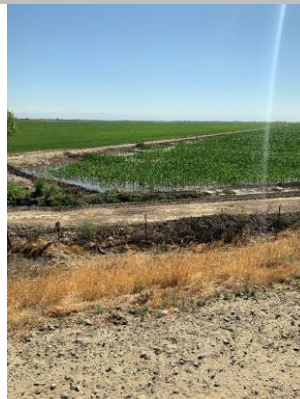
Photo 2 of 3 : UCIP\_FA\_2021\_70160\_104283.jpg

View of LS from crown.

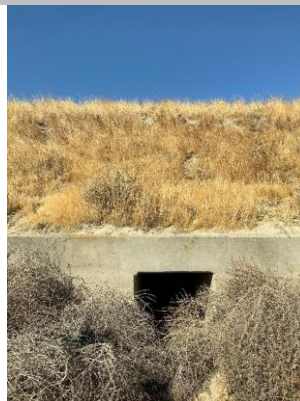
Photo 3 of 3 : UCIP\_FA\_2021\_70160\_104285.jpg

LS view from toe: concrete headwall at inlet.

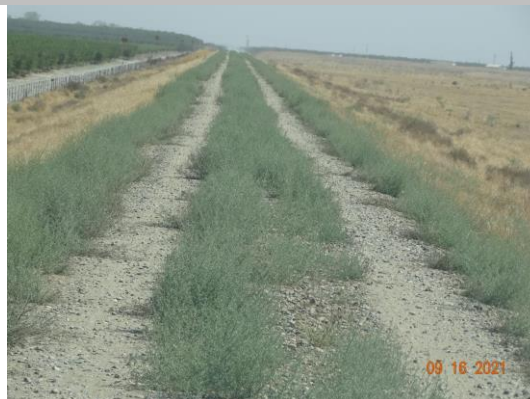
Photo 1 of 1 : FA\_2021\_NA0010\_123\_172\_20210929\_00343.jpg

LM Start	31.49	Rating **	M	Issue No.	172
LM End	32.23	Issue Type +	Ma	Location *	CR
Category	Earthen Levee			GPS Latitude/Longitude	
				Start	End
Item	Vegetation			36.999637 °	36.990404 °
				-120.413936 °	-120.403691 °
DWR ID	DWR_NA0010_05_f_2021_172				
Comment Code					
V9 : Keep the crown roadway free of vegetation.					
Inspector Comment

View of vegetation on the levee crown. (Fall 2021)

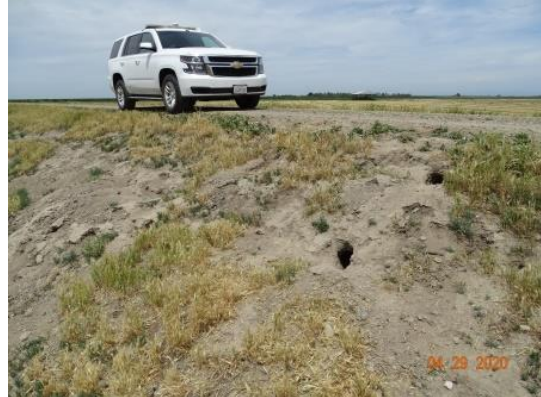
Photo 1 of 1 : FA\_2021\_NA0010\_123\_230\_20210830\_00054.jpg

LM Start	31.66	Rating **	U	Issue No.	230
LM End	31.66	Issue Type +	Ma	Location *	WS
Category	Earthen Levee			GPS Latitude/Longitude	
				Start	End
Item	Animal Control			36.997828 °	36.997828 °
				-120.411920 °	-120.411920 °
DWR ID	DWR_NA0010_05_s_2020_230				
Comment Code					
A3 : No rodents visible, but rodent burrows visible; need to backfill and compact or grout burrows.					
Inspector Comment					
Several rodent burrows in the waterside slope and shoulder.

Rodent burrows in the waterside slope. (Spring 2020)

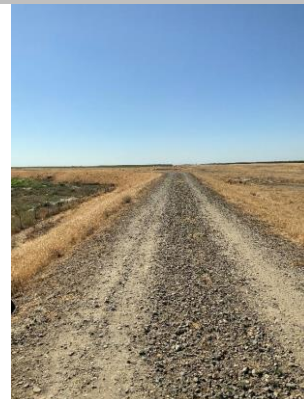
Photo 1 of 3 : UCIP\_FA\_2021\_70195\_104275.jpg

Comment Code					
Inspector Comment					
DS_ID:19699 FS_ID:70195 EP_NO: N/A Repair Type: Non-Urgent EVAL Issue: Limited Inspection/No UCIP Evaluation Crossing Status: Found UCIP Comments: 06/24/2021 The record has been upgraded from No Action Needed to Non-Urgent. Limited inspection of LS due to dense vegetation; recommend removal. Wooden planks propping flapgate on WS open; recommend removal before flood season. No permit was found authorizing this encroachment. CVFPB will need to review crossing to determine owner. The UCIP inspection was completed with GEI staff, H.Dunn. (P.Espinoza – GEI) FIELD_STRUCT_DESC: 48-inch by 36-inch reinforced concrete box gravity drainage culvert through the levee, 14.5 feet below the crown. Flap gate on the waterside (WS) end. Concrete U-shaped headwall on each end. [Additional Reference(s): DWR Levee Log, 2002 (HLM 31.64), listed as a 48-inch by 36-inch reinforced concrete box culvert (RCBC). USACE San Joaquin O&M Manual, Unit 601 Part 1 (SJR601.1), 1967, Revised 25 May 2011, (HLM 31.64), listed as a 4-feet by 3-feet RCBC] FS Date: 6/24/2021 2:15:00 PM

View from levee crown.

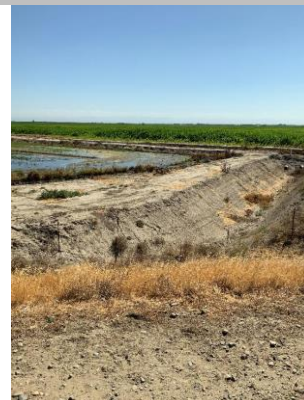
Photo 2 of 3 : UCIP\_FA\_2021\_70195\_104276.jpg

LS view from crown.

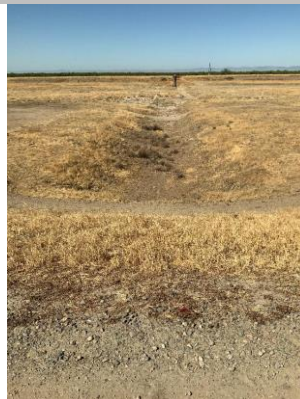
Photo 3 of 3 : UCIP\_FA\_2021\_70195\_104277.jpg

WS view from crown.

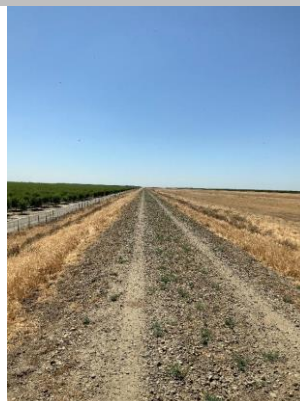
Photo 1 of 3 : UCIP\_FA\_2021\_70162\_104269.jpg

DS\_ID:19700  
 FS\_ID:70162  
 EP\_NO: N/A  
 Repair Type: Non-Urgent  
 EVAL Issue: Maintenance Compliance Issue  
 Crossing Status: Found  
 UCIP Comments: 06/23/2021 The record remains Non-Urgent. Some tumbleweed buildup at LS inlet and WS flapgate, recommend removal. No permit was found authorizing this encroachment. CVFPB will need to review crossing to determine owner. The UCIP inspection was completed with GEI staff, H.Dunn. (P.Espinoza – GEI) 04/01/2014  
 Dense vegetation limits the inspector's visibility to identify signs of pipe failure (leaks) along the landward slope. Recommend removing vegetation along pipe alignment to conduct proper inspection of structure. (W. Wylie - DWR UCIP)  
 FIELD\_STRUCT\_DESC: 30-inch by 30-inch reinforced concrete box gravity drainage culvert through the levee, 13 feet below the crown. Flap gate on the waterside (WS) end. Concrete headwall on the landside (LS) end with flashboard attachment. Concrete U-shaped headwall on the WS end. [Additional Reference(s): DWR Levee Log, 2002 (HLM 31.69), listed as a 30-inch square reinforced concrete box culvert (RCBC). USACE San Joaquin O&M Manual, Unit 601 Part 1 (SJR601.1), 1967, Revised 25 May 2011, (HLM 31.71), listed as a 2.6-feet by 2.6-feet RCBC]

View from levee crown.

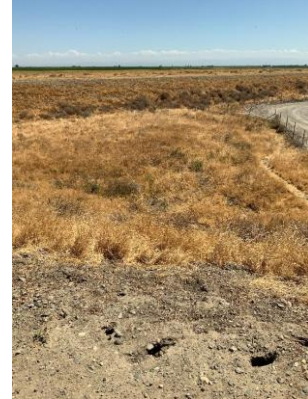
Photo 2 of 3 : UCIP\_FA\_2021\_70162\_104268.jpg

LS view from crown.

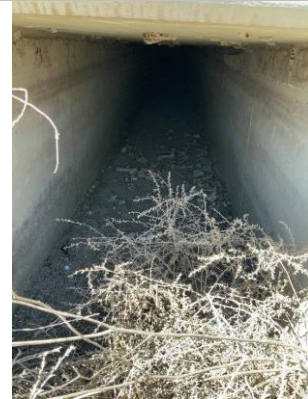
Photo 3 of 3 : UCIP\_FA\_2021\_70162\_104272.jpg

LS view: inside view of inlet.

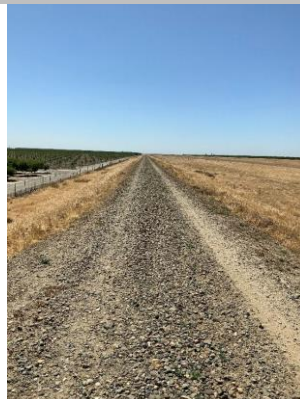
Photo 1 of 3 : UCIP\_FA\_2021\_70163\_104261.jpg

Comment Code					
Inspector Comment					
DS_ID:19701 FS_ID:70163 EP_NO: N/A Repair Type: Non-Urgent EVAL Issue: Limited Inspection/No UCIP Evaluation Crossing Status: Found UCIP Comments: 06/23/2021 The record remains Non-Urgent. Limited inspection of LS inlet due to dense vegetation; recommend removal. No permit was found authorizing this encroachment. CVFPB will need to review crossing to determine owner. The UCIP inspection was completed with GEI staff, H.Dunn. (P.Espinoza – GEI) 04/01/2014 Some silt buildup inside culvert. (W. Wylie - DWR UCIP) FIELD_STRUCT_DESC: 30-inch by 30-inch reinforced concrete box gravity drainage culvert through the levee, 14.2 feet below the crown. Flap gate on the waterside (WS) end. Concrete headwall on the landside (LS) end with flashboard attachment. Concrete U-shaped headwall on the WS end. [Additional Reference(s): DWR Levee Log, 2002 (HLM 32.22), listed as a 30-inch square reinforced concrete box culvert (RCBC). USACE San Joaquin O&M Manual, Unit 601 Part 1 (SJR601.1), 1967, Revised 25 May 2011, (HLM 32.22), listed as a 2.6-feet by 2.6-feet RCBC] FS Date: 6/23/2021 1:18:00 PM

View from levee crown.

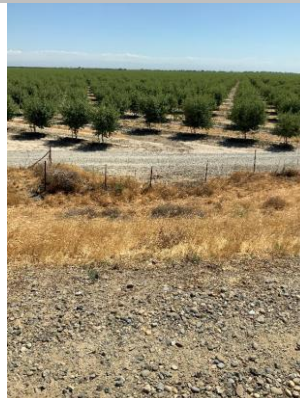
Photo 2 of 3 : UCIP\_FA\_2021\_70163\_104262.jpg

LS view from crown.

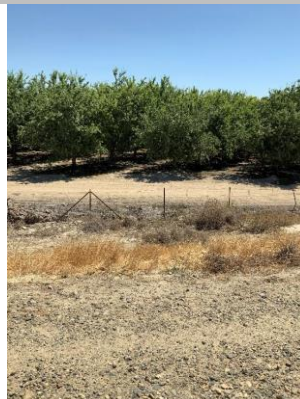
Photo 2 of 3 : UCIP\_FA\_2021\_70164\_104256.jpg

LS view from crown.

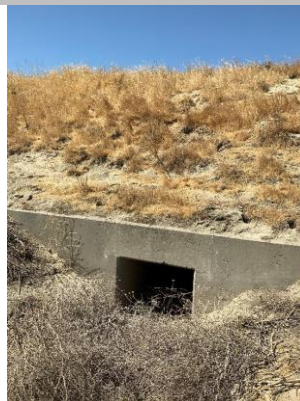
Photo 3 of 3 : UCIP\_FA\_2021\_70164\_104257.jpg

LS view from toe: concrete headwall at inlet.

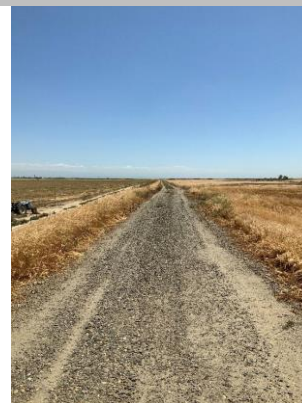
Photo 1 of 3 : UCIP\_FA\_2021\_70165\_104247.jpg

Comment Code						
Inspector Comment						
DS_ID:19703 FS_ID:70165 EP_NO: N/A Repair Type: Non-Urgent EVAL Issue: Limited Inspection/No UCIP Evaluation Crossing Status: Found UCIP Comments: 06/24/2021 The record remains Non-Urgent. Limited inspection of LS and WS due to dense vegetation; recommend removal. No permit was found authorizing this encroachment. CVFPB will need to review crossing to determine owner. The UCIP inspection was completed with GEI staff, H.Dunn. (P.Espinoza – GEI)  04/01/2014 Dense vegetation limits the inspector's visibility to identify signs of pipe failure (leaks) along the slopes. Recommend removing vegetation along pipe alignment to conduct proper inspection of structure. (W. Wylie - DWR UCIP) FIELD_STRUCT_DESC: 30-inch by 30-inch reinforced concrete box gravity drainage culvert through the levee, 13.9 feet below the crown. Flap gate on the waterside (WS) end. Concrete headwall on the landside (LS) end. Concrete U-shaped headwall on the WS end. [Additional Reference(s): DWR Levee Log, 2002 (HLM 33.72), listed as a 30-inch square reinforced concrete box culvert (RCBC). USACE San Joaquin O&M Manual, Unit 601 Part 1 (SJR601.1), 1967, Revised 25 May 2011, (HLM 33.72), listed as a 2.6-feet by 2.6-feet RCBC] FS Date: 6/24/2021 12:30:00 PM

View from levee crown.

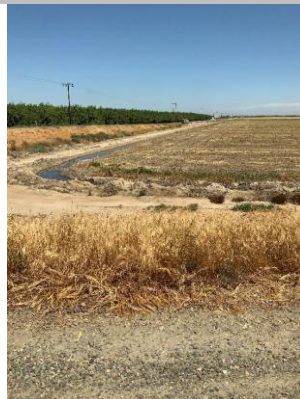
Photo 2 of 3 : UCIP\_FA\_2021\_70165\_104249.jpg

LS view from crown.

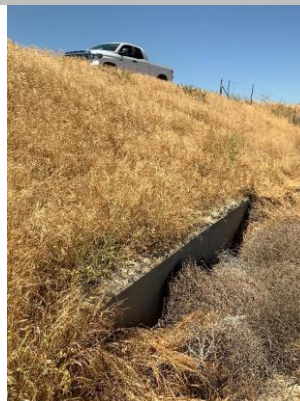
Photo 3 of 3 : UCIP\_FA\_2021\_70165\_104252.jpg

LS view from toe: concrete headwall and inlet.

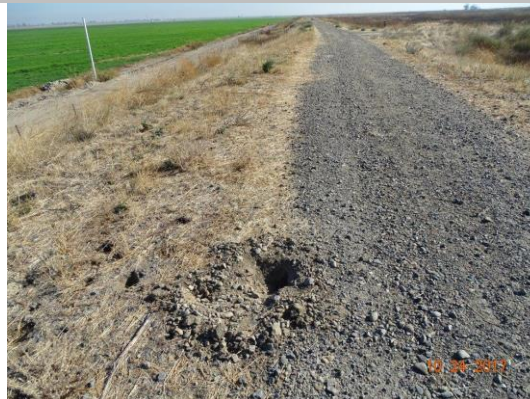
Photo 1 of 1 : FA\_2021\_NA0010\_123\_130\_20210830\_00030.jpg

LM Start	33.82	Rating **	M	Issue No.	130
LM End	33.82	Issue Type +	Ma	Location *	LS
Category	Earthen Levee			GPS Latitude/Longitude	
				Start	End
Item	Animal Control			36.976849 °	36.976849 °
				-120.382393 °	-120.382393 °
DWR ID	DWR_NA0010_05_f_2017_130				
Comment Code					
A3 : No rodents visible, but rodent burrows visible; need to backfill and compact or grout burrows.					
Inspector Comment

Looking east at the landside shoulder.

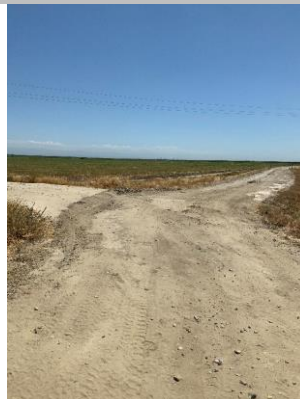
Photo 1 of 3 : UCIP\_FA\_2021\_70196\_104240.jpg

Comment Code						
Inspector Comment						
DS_ID:19755 FS_ID:70196 EP_NO: N/A Repair Type: Non-Urgent EVAL Issue: Limited Inspection/No UCIP Evaluation Crossing Status: Found UCIP Comments: 06/24/2021 The record remains Non-Urgent. Limited inspection of WS and LS due to dense vegetation, recommend removal. No permit was found authorizing this encroachment. CVFPB will need to review crossing to determine owner. The UCIP inspection was completed with GEI staff, H.Dunn. (P.Espinoza – GEI)  04/01/2014 Dense vegetation limits the inspector's visibility to identify signs of pipe failure (leaks) along the landward slope. Recommend removing vegetation along pipe alignment to conduct proper inspection of structure. Debris buildup visible on waterward headwall--recommend contacting owner to clear pipe. (W. Wylie - DWR UCIP) FIELD_STRUCT_DESC: [Chowchilla Canal Irrigation Structure] 36-inch by 36-inch reinforced concrete box gravity irrigation culvert through the levee, 9.7 feet below the crown. Slide gate in a 56-inch by 91-inch concrete riser on the waterside (WS) slope. Concrete U-shaped headwall on each end. Landside channel cobble revetted for 8 feet. [Additional Reference(s): DWR Levee Log, 2002 (HLM 34.51), listed as a 36-inch square reinforced concrete box culvert (RCBC) referenced as the Chowchilla Canal Irrigation Structure. USACE San Joaquin O&M Manual, Unit 601 Part 1 (SJR601.1), 1967, Revised 25 May 2011, (HLM 34.51), listed as a 3-feet by 3-feet RCBC referenced as the Chowchilla Canal Irrigation Structure] FS Date: 6/24/2021 11:58:00 AM

View of levee crown.

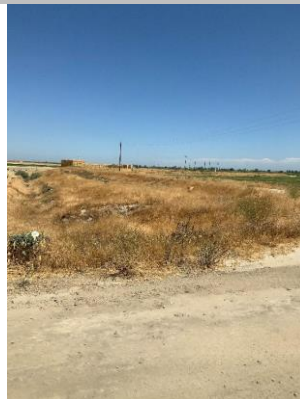
Photo 2 of 3 : UCIP\_FA\_2021\_70196\_104241.jpg

LS view from crown.

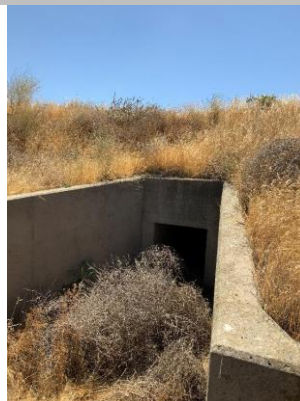
Photo 3 of 3 : UCIP\_FA\_2021\_70196\_104243.jpg

LS view from toe: concrete headwall and inlet.

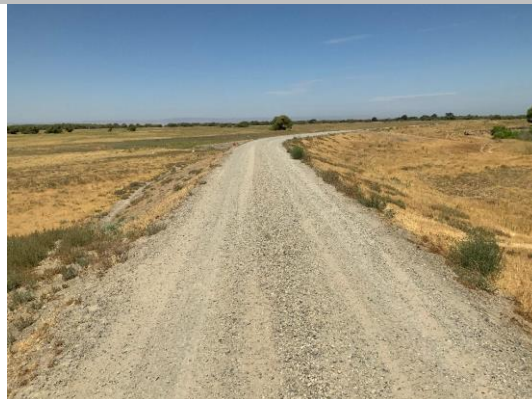
Photo 1 of 3 : UCIP\_FA\_2021\_69948\_102869.jpg

DS\_ID:19815  
FS\_ID:69948  
EP\_NO: N/A  
Repair Type: Non-Urgent  
EVAL Issue: Unauthorized Encroachment, installed decades prior  
Crossing Status: Found  
UCIP Comments: 07/27/2021 The record remains Non-Urgent. Crossing appears to be in good condition and there is no longer sediment buildup. No permit was found authorizing this encroachment. CVFPB will need to review crossing to determine owner. The UCIP inspection was completed with GEI staff, P. Espinoza. (H. Dunn – GEI)

Levee crown.

04/18/2014 Need to contact owner. Sediment buildup on landward side. Recommend removing sediment buildup on landward toe. (O. Magana - DWR UCIP)  
FIELD\_STRUCT\_DESC: 24-inch corrugated metal irrigation discharge pipe through the levee, 7.2 feet below the crown. Pump on concrete structure in the channel. Slide gate in a 36-inch corrugated metal pipe (CMP) riser on the waterside (WS) slope. Concrete headwall on each end. [Additional Reference(s): DWR Levee Log, 2002 (HLM 0.74), listed as a 24-inch corrugated metal pipe (CMP). USACE San Joaquin O&M Manual, Unit 601 Part 1 (SRJ601.1), 1967, Revised 25 May 2011, (HLM 0.74), listed as a 24-inch CMP]  
FS Date: 7/27/2021

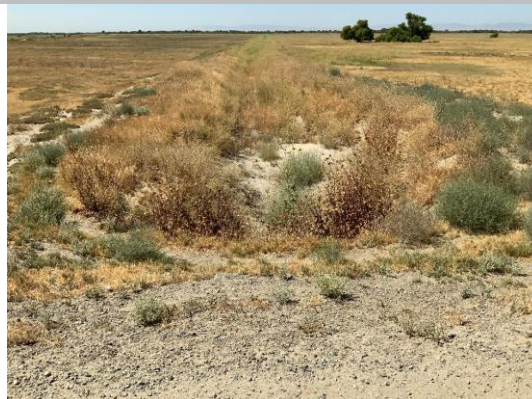
Photo 2 of 3 : UCIP\_FA\_2021\_69948\_102870.jpg

LS view: Toe from crown.

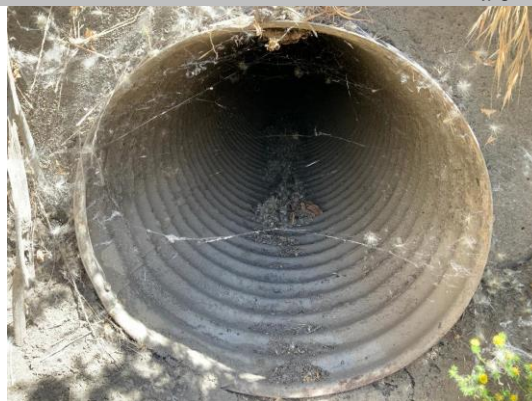
Photo 3 of 3 : UCIP\_FA\_2021\_69948\_102871.jpg

LS view: Closeup of pipe outlet at toe.

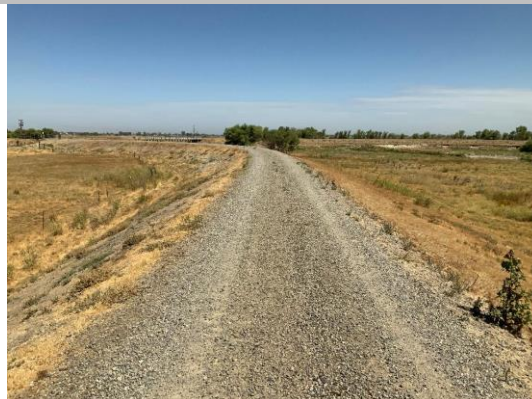
Photo 1 of 3 : UCIP\_FA\_2021\_68724\_102876.jpg

Comment Code						
Inspector Comment						
DS_ID:19816 FS_ID:68724 EP_NO: N/A Repair Type: Non-Urgent EVAL Issue: Limited Inspection/No UCIP Evaluation Crossing Status: Found UCIP Comments: 07/27/2021 The record remains Non-Urgent. LS pipe inlet is blocked by barbed wire, limited access and inspection. No permit was found authorizing this encroachment. CVFPB will need to review crossing to determine owner. The UCIP inspection was completed with GEI staff, P. Espinoza. (H. Dunn – GEI) 04/18/2014 Landward side blocked--need to contact owner to determine status of crossing. (O. Magana - DWR UCIP) FIELD_STRUCT_DESC: 24-inch corrugated metal gravity drainage pipe through the levee, 16.2 feet below the crown. Flap gate on the waterside (WS) end. Concrete U-shaped headwall on each end. [Additional Reference(s): DWR Levee Log, 2002 (HLM 0.86), listed as a 24-inch corrugated metal pipe (CMP). USACE San Joaquin O&M Manual, Unit 601 Part 1 (SRJ601.1), 1967, Revised 25 May 2011, (HLM 0.86), listed as a 24-inch CMP] FS Date: 7/27/2021

Levee crown.

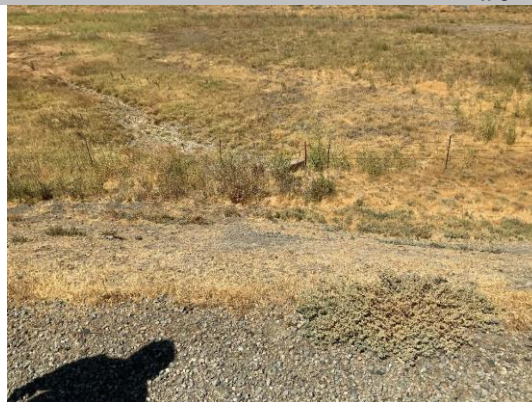
Photo 2 of 3 : UCIP\_FA\_2021\_68724\_102877.jpg

LS view: Toe from crown.

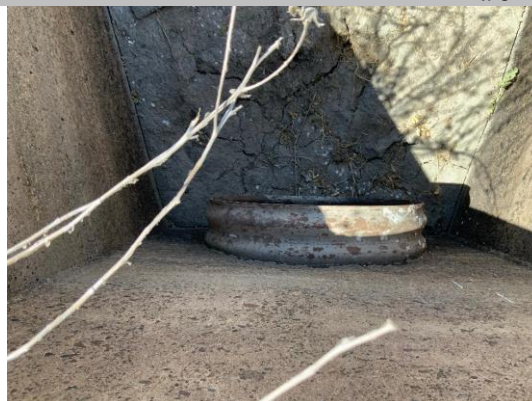
Photo 3 of 3 : UCIP\_FA\_2021\_68724\_102879.jpg

LS view: Top view of pipe inlet at toe.

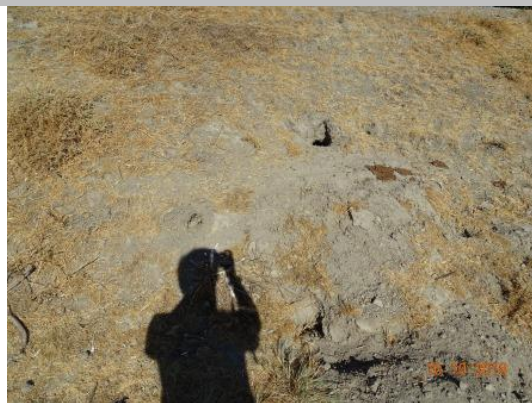
Photo 1 of 1 : FA\_2021\_NA0010\_124\_93\_20210830\_00026.jpg

LM Start	1.18	Rating **	U	Issue No.	93
LM End	1.18	Issue Type +	Ma	Location *	LS
Category	Earthen Levee			GPS Latitude/Longitude	
				Start	End
Item	Animal Control			37.267101 °	37.267101 °
				-120.809603 °	-120.809603 °
DWR ID	DWR_NA0010_06_f_2018_93				
Comment Code					
A3 : No rodents visible, but rodent burrows visible; need to backfill and compact or grout burrows.					
Inspector Comment					
Several rodent burrows including large burrows were observed at this location.

View of landside slope. (Fall 2018)

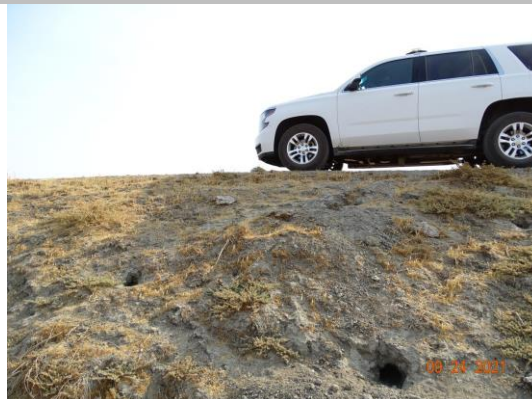
Photo 1 of 1 : FA\_2021\_NA0010\_124\_127\_20210929\_00213.jpg

LM Start	1.52	Rating **	M	Issue No.	127
LM End	1.52	Issue Type +	Ma	Location *	LS
Category	Earthen Levee			GPS Latitude/Longitude	
				Start	End
Item	Animal Control			37.263176 °	37.263176 °
				-120.805983 °	-120.805983 °
DWR ID	DWR_NA0010_06_f _ 2021_127				
Comment Code					
A3 : No rodents visible, but rodent burrows visible; need to backfill and compact or grout burrows.					
Inspector Comment

View of rodent burrows in the landside slope. (Fall 2021)

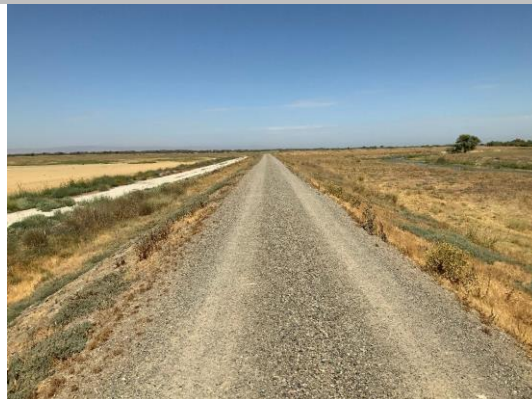
Photo 1 of 3 : UCIP\_FA\_2021\_69794\_102901.jpg

Comment Code						
Inspector Comment						
DS_ID:19817 FS_ID:69794 EP_NO: N/A Repair Type: Non-Urgent EVAL Issue: Limited Inspection/No UCIP Evaluation Crossing Status: Found UCIP Comments: 07/27/2021 The record remains Non-Urgent. LS pipe inlet inaccessible due to barbed wire and not visible due to dense vegetation, limited inspection and recommend removing vegetation. No permit was found authorizing this encroachment. CVFPB will need to review crossing to determine owner. The UCIP inspection was completed with GEI staff, P. Espinoza. (H. Dunn – GEI) 04/18/2014 No access was available to landward side due to fence. Recommend removing some of the vegetation on waterward toe. (O. Magana - DWR UCIP) FIELD_STRUCT_DESC: 24-inch corrugated metal gravity drainage pipe through the levee, 13.5 feet below the crown. Flap gate on the waterside (WS) end. Concrete headwall on each end. [Additional Reference(s): DWR Levee Log, 2002 (HLM 1.96), listed as a 24-inch corrugated metal pipe (CMP). USACE San Joaquin O&M Manual, Unit 601 Part 1 (SRJ601.1), 1967, Revised 25 May 2011, (HLM 1.95), listed as a 24-inch CMP] FS Date: 7/27/2021

Levee crown.

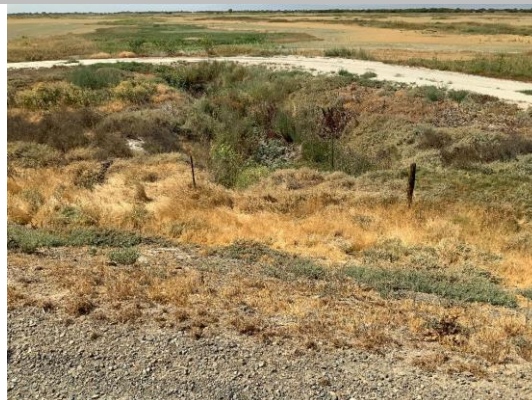
Photo 2 of 3 : UCIP\_FA\_2021\_69794\_102902.jpg

LS view: Toe from crown.

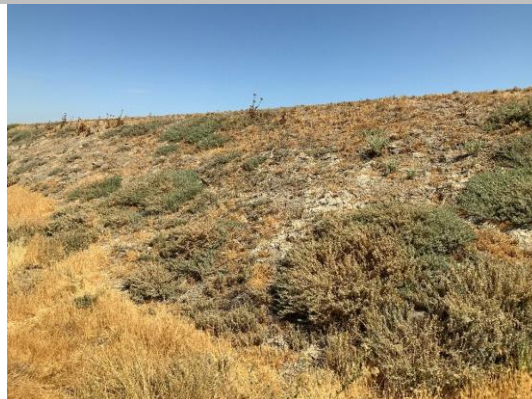
Photo 3 of 3 : UCIP\_FA\_2021\_69794\_102903.jpg

LS view: Slope from toe.

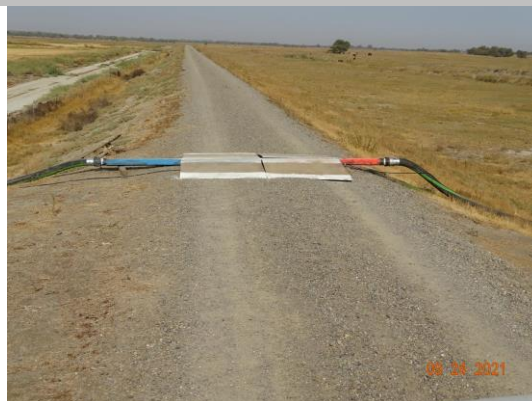
Photo 1 of 1 : FA\_2021\_NA0010\_124\_123\_20210929\_00215.jpg

LM Start	2.07	Rating **	M	Issue No.	123
LM End	2.07	Issue Type +	En	Location *	CR
Category	Earthen Levee			GPS Latitude/Longitude	
				Start	End
Item	Encroachments			37.257848 °	37.257848 °
				-120.799668 °	-120.799668 °
DWR ID	DWR_NA0010_06_f _ 2021_123				
Comment Code					
PI : Pipe					
Inspector Comment					
Temporary pipe placed across the levee crown.

Temporary pipe placed across the levee crown. (Fall 2021)

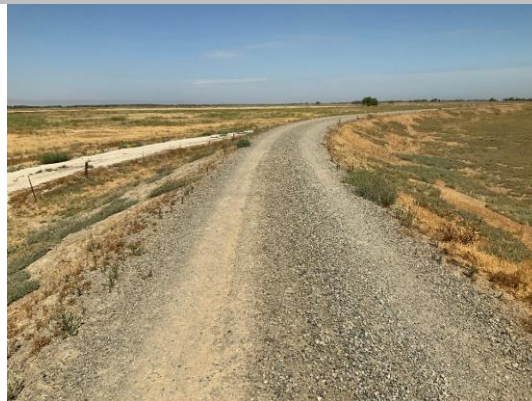
Photo 1 of 3 : UCIP\_FA\_2021\_69791\_102913.jpg

Comment Code						
Inspector Comment						
DS_ID:19818 FS_ID:69791 EP_NO: N/A Repair Type: Non-Urgent EVAL Issue: Pipe Damage Crossing Status: Found UCIP Comments: 07/27/2021 The record remains Non-Urgent. DWR DMP internal inspection has found pipe integrity issues. LOF of crossing is between 4.1 and 5. Crossing will be monitored until funding becomes available for rehabilitation. No permit was found authorizing this encroachment. CVFPB will need to review crossing to determine owner. The UCIP inspection was completed with GEI staff, P. Espinoza. (H. Dunn – GEI) 04/18/2014 Need to contact owner. Sediment buildup in pipe visible on landward side. (O. Magana - DWR UCIP) FIELD_STRUCT_DESC: 36-inch corrugated metal gravity drainage pipe through the levee, 6.9 feet below the crown. Slide gate in a 48-inch corrugated metal pipe (CMP) riser on the waterside (WS) slope. Concrete headwall on each end. [Additional Reference(s): DWR Levee Log, 2002 (HLM 2.61), listed as a 36-inch corrugated metal pipe (CMP). USACE San Joaquin O&M Manual, Unit 601 Part 1 (SRJ601.1), 1967, Revised 25 May 2011, (HLM 2.61), listed as a 36-inch CMP] FS Date: 7/27/2021

Levee crown.

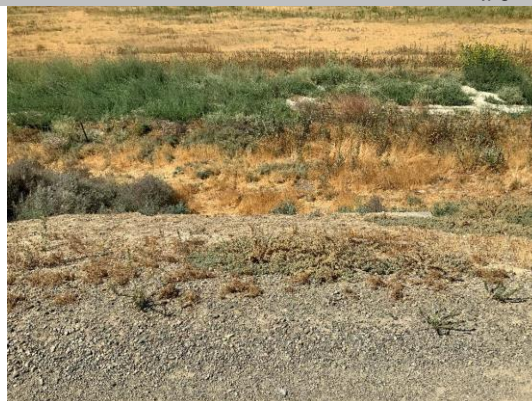
Photo 2 of 3 : UCIP\_FA\_2021\_69791\_102914.jpg

LS view: Headwall visible at toe from crown.

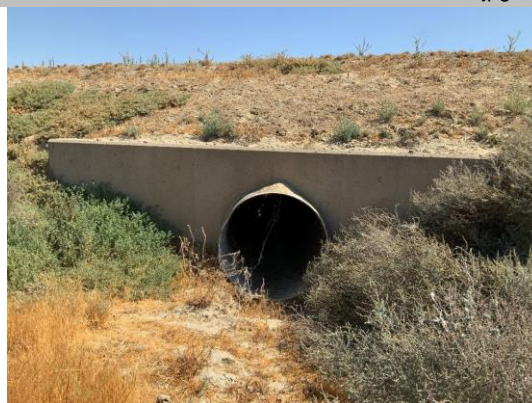
Photo 3 of 3 : UCIP\_FA\_2021\_69791\_102915.jpg

LS view: Headwall and slope from toe.

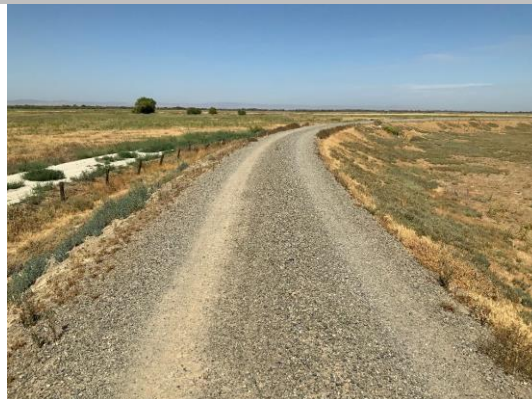
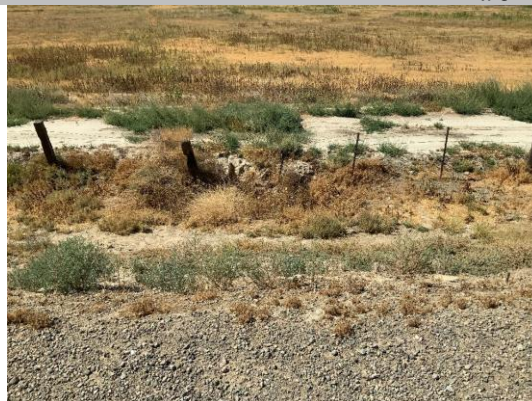
Photo 1 of 3 : UCIP\_FA\_2021\_69795\_102919.jpg

DS\_ID:19819  
FS\_ID:69795  
EP\_NO: N/A  
Repair Type: Non-Urgent  
EVAL Issue: Pipe Damage  
Crossing Status: Found  
UCIP Comments: 07/27/2021 The record remains Non-Urgent. DWR DMP internal inspection has found pipe integrity issues. LOF of crossing is between 4.1 and 5. Crossing will be monitored until funding becomes available for rehabilitation. Dense vegetation covering LS pipe inlet, limited inspection and recommend removal. No permit was found authorizing this encroachment. CVFPB will need to review crossing to determine owner. The UCIP inspection was completed with GEI staff, P. Espinoza. (H. Dunn – GEI) 04/18/2014 Dense vegetation limits the inspector's visibility to identify signs of pipe condition on landward toe--headwall blocked by dense vegetation. Recommend removing vegetation from landward toe. (O. Magana - DWR UCIP)  
FIELD\_STRUCT\_DESC: 24-inch corrugated metal gravity drainage pipe through the levee, 9.2 feet below the crown. Flap gate on the waterside (WS) end. Concrete headwall on each end. [Additional Reference(s): DWR Levee Log, 2002 (HLM 2.65), listed as a 24-inch corrugated metal pipe (CMP). USACE San Joaquin O&M Manual, Unit 601 Part 1 (SRJ601.1), 1967, Revised 25 May 2011, (HLM 2.65), listed as a 24-inch CMP]

Levee crown.

LS view: Toe from crown.

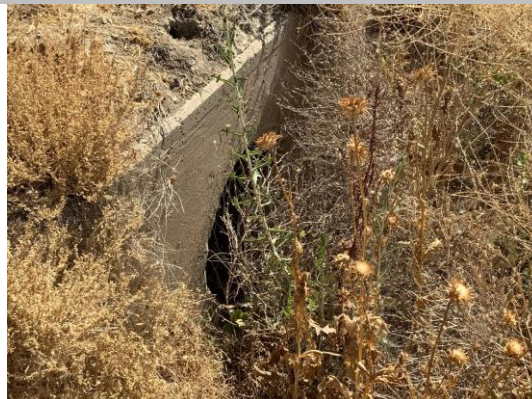
Photo 3 of 3 : UCIP\_FA\_2021\_69795\_102921.jpg

LS view: Closeup of pipe inlet at toe with dense vegetation.

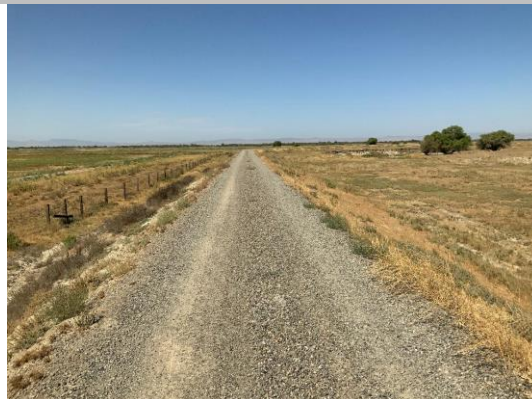
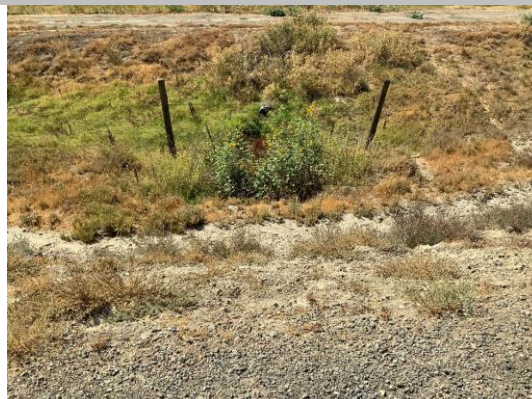
Photo 1 of 3 : UCIP\_FA\_2021\_70041\_102928.jpg

DS\_ID:19820  
FS\_ID:70041  
EP\_NO: N/A  
Repair Type: Urgent  
EVAL Issue: Pipe Integrity  
Crossing Status: Found  
UCIP Comments: 07/27/2021 The record has been upgraded from Non-Urgent to Urgent. DWR DMP internal inspection has found pipe integrity issues. LOF of crossing is greater than or equal to 5 and less than 6. Crossing will be monitored until funding becomes available to address the issues. Dense vegetation covering LS pipe inlet, limited inspection and recommend removal of vegetation. Some minor erosion under WS concrete pad, less than a foot in length. No permit was found authorizing this encroachment. CVFPB will need to review crossing to determine owner. The UCIP inspection was completed with GEI staff, P. Espinoza. (H. Dunn – GEI) 04/18/2014. Dense vegetation limits the inspector's visibility to identify signs of pipe condition on landward toe--headwall blocked by dense vegetation. Recommend removing vegetation from landward toe. (O. Magana - DWR UCIP)

Levee crown.

LS view: Toe from crown.

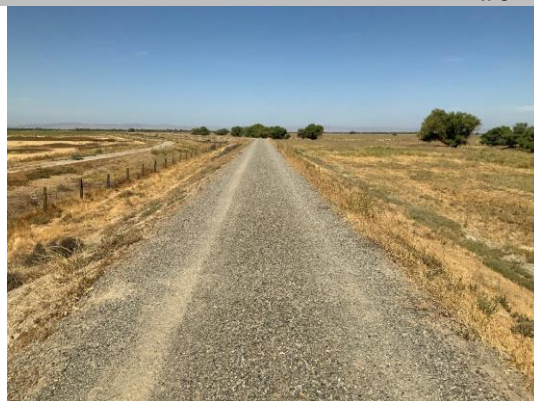
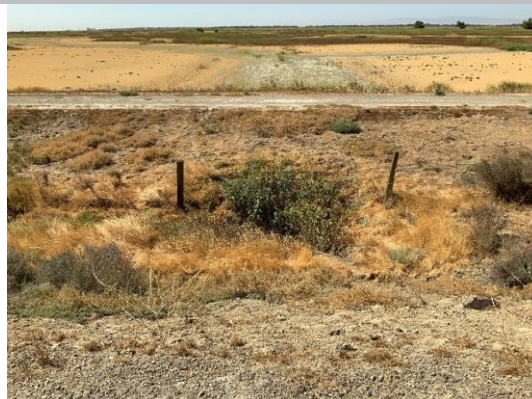
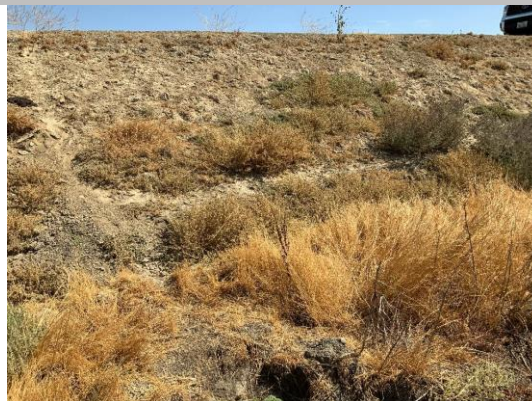
DS\_ID:19821  
 FS\_ID:69797  
 EP\_NO: N/A  
 Repair Type: Non-Urgent  
 EVAL Issue: Limited Inspection/No UCIP Evaluation  
 Crossing Status: Found  
 UCIP Comments: 07/27/2021 The record remains Non-Urgent. Limited inspection due to sediment and debris buildup inside LS pipe inlet, recommend removal. Sediment buildup keeping WS flapgate open, recommend removal. No permit was found authorizing this encroachment. CVFPB will need to review crossing to determine owner. The UCIP inspection was completed with GEI staff, P. Espinoza. (H. Dunn – GEI) 04/18/2014 Dense vegetation limits the inspector's visibility to identify signs of pipe condition on landward toe--headwall blocked by dense vegetation. Recommend removing vegetation from landward toe. (O. Magana - DWR UCIP)  
 FIELD\_STRUCT\_DESC: 24-inch corrugated metal gravity drainage pipe through the levee, 11.2 feet below the crown. Flap gate on the waterside (WS) end. Concrete headwall on each end. [Additional Reference(s): DWR Levee Log, 2002 (HLM 3.09), listed as a 24-inch corrugated metal pipe (CMP). USACE San Joaquin O&M Manual, Unit 601 Part 1 (SRJ601.1), 1967, Revised 25 May 2011, (HLM 3.09), listed as a 24-inch CMP]

Levee crown.

LS view: Toe from crown.

LS view: Slope from toe.

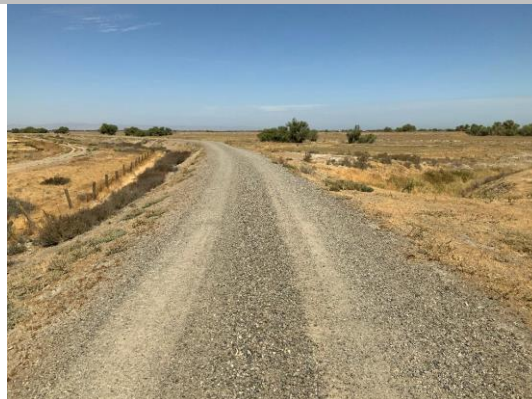
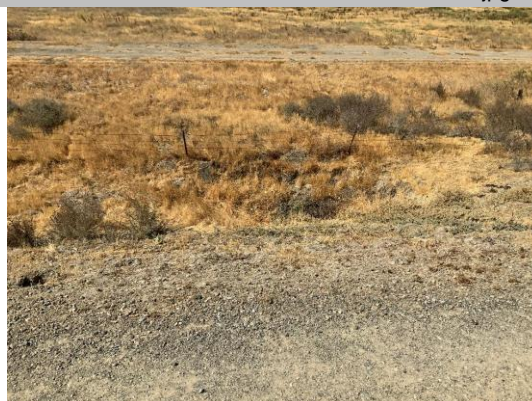
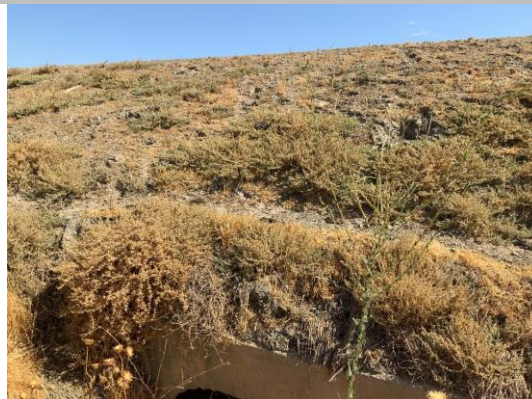
DS\_ID:19822  
FS\_ID:69950  
EP\_NO: N/A  
Repair Type: Non-Urgent  
EVAL Issue: Pipe Damage  
Crossing Status: Found  
UCIP Comments: 07/27/2021 The record remains Non-Urgent. DWR DMP internal inspection has found pipe integrity issues. LOF of crossing is between 4.1 and 5. Crossing will be monitored until funding becomes available for rehabilitation. There is minor separation of the CMP and concrete headwall on the LS toe. No permit was found authorizing this encroachment. CVFPB will need to review crossing to determine owner. The UCIP inspection was completed with GEI staff, P. Espinoza. (H. Dunn – GEI) 04/18/2014 Dense vegetation limits the inspector's visibility to identify signs of pipe condition on waterward slope and landward toe (headwall blocked by dense vegetation). Recommend removing vegetation from landward toe. (O. Magana - DWR UCIP)  
FIELD\_STRUCT\_DESC: 24-inch corrugated metal gravity drainage pipe through the levee, 10.4 feet below the crown. Flap gate on the waterside (WS) end. Concrete headwall on each end. [Additional Reference(s): DWR Levee Log, 2002 (HLM 3.29), listed as a 24-inch corrugated metal pipe (CMP). USACE San Joaquin O&M Manual, Unit 601 Part 1 (SRJ601.1), 1967, Revised 25 May 2011, (HLM 3.29), listed as a 24-inch CMP]

Levee crown.

LS view: Toe from crown.

LS view: Slope from toe.

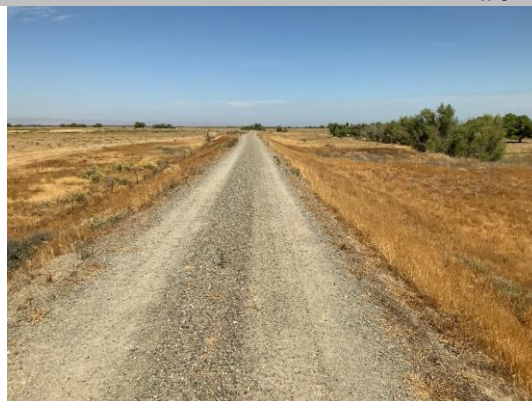
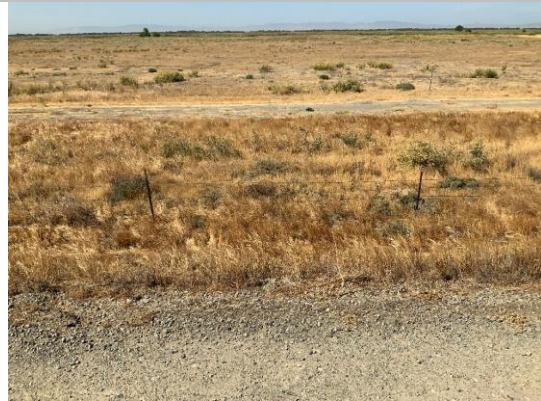
DS\_ID:19823  
 FS\_ID:69951  
 EP\_NO: N/A  
 Repair Type: Non-Urgent  
 EVAL Issue: Pipe Not Found  
 Crossing Status: Not Found  
 UCIP Comments: 07/27/2021 The record remains Non-Urgent. No signs of pipe, headwalls, or flapgate found on WS or LS. Confirm with owner on the status of this pipe. No permit was found authorizing this encroachment. CVFPB will need to review crossing to determine owner. The UCIP inspection was completed with GEI staff, P. Espinoza. (H. Dunn – GEI) 04/18/2014 Alignment of crossing unknown--altered crossing. No headwall found on landward side only siphon breaker found a short distance from landward toe. Tall grass observed on waterward slope and some burrow activity also noticed. Need to contact owner to determine alignment of crossing and status of crossing. (O. Magana - DWR UCIP)  
 FIELD\_STRUCT\_DESC: 36-inch corrugated metal gravity drainage pipe through the levee, 15.7 feet below the crown. Flap gate on the waterside (WS) end. Concrete U-shaped headwall on each end. Bench mark (BM) stamped 9770-152 on top of the WS headwall. [Additional Reference(s): DWR Levee Log, 2002 (HLM 3.44), listed as a 36-inch corrugated metal pipe (CMP). USACE San Joaquin O&M Manual, Unit 601 Part 1 (SRJ601.1), 1967, Revised 25 May 2011, (HLM 3.43), listed as a 36-inch CMP]

Levee crown.

LS view: Toe from crown.
