## Flood Control Project Maintenance Levee Inspections

### Fall 2021 Levee Maintenance Deficiency Summary Report

#### San Joaquin River Basin

NA0010 Lower San Joaquin Levee District	Overall LMA Rating	Total LMA Miles							
	U	191.27							
Rated Item	Maintenance Deficiency				Enforcement		Design & System Obsolescence		
	M Miles	U Miles	M + 4U Miles	Threshold %	M Miles	U Miles	M Miles	U Miles	
<i>Earthen Levee</i>									
Vegetation	47.00	9.57	85.28	44.59%					
Trim / Thin Trees	0.10		0.10	0.05%					
Encroachments	0.23	0.02	0.31	0.16%	9.29	0.59			
Animal Control	7.67	2.19	16.43	8.59%					
Slope Stability	0.05	0.01	0.09	0.05%					
Erosion / Bank Caving	0.13	0.81	3.37	1.76%					
Crown Surface / Depressions / Rutting	0.01		0.01	0.01%					
Repair Gates	0.02	0.02	0.10	0.05%					
<i>Rivers, Channels &amp; Designated Floodways</i>									
Encroachments					0.01	0.01			
<i>Supplemental</i>									
DWR Erosion Survey	0.12	0.17	0.80	0.42%					
DWR UCIP Field Study					1.29	0.05			
DWR UCIP LMA Responsibility									
<i>LMA Totals:</i>	55.33	12.79	106.49	55.67%	10.59	0.65	0.00	0.00

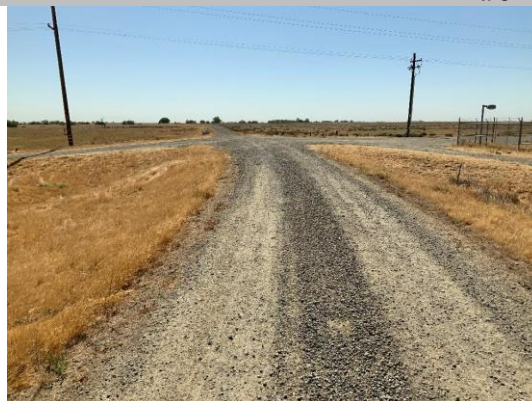
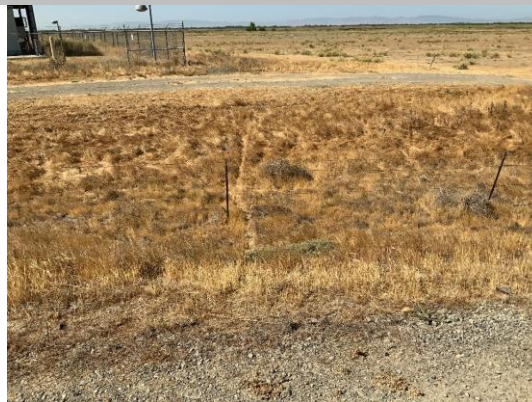
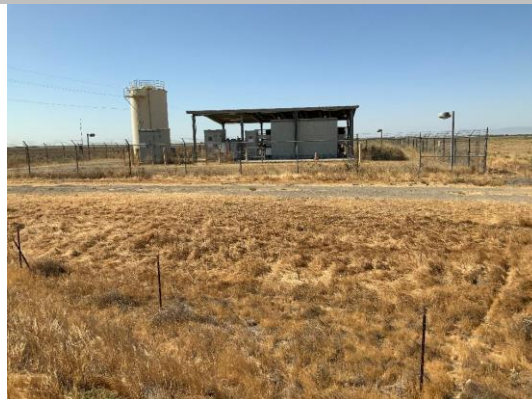
DS\_ID:19824  
FS\_ID:69952  
EP\_NO: 6965  
Repair Type: Non-Urgent  
EVAL Issue: Unauthorized Modification or Non-Compliant Permit  
Crossing Status: Indicator Found  
UCIP Comments: 07/27/2021 The record remains Non-Urgent. Crossing appears to be modified, there is no WS pump or platform. No sign of pipe visible on LS, unless pipe goes to large plant facility off the toe. Confirm with owner on the alignment and status of pipe. The UCIP inspection was completed with GEI staff, P. Espinoza. (H. Dunn – GEI)

Levee crown.

LS view: Toe from crown, no pipe visible.

LS view: Plant facility visible off the toe from crown.

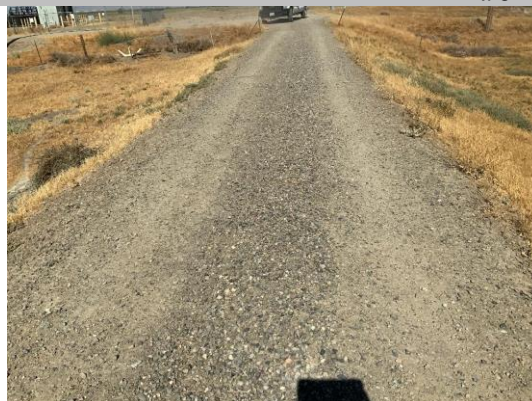
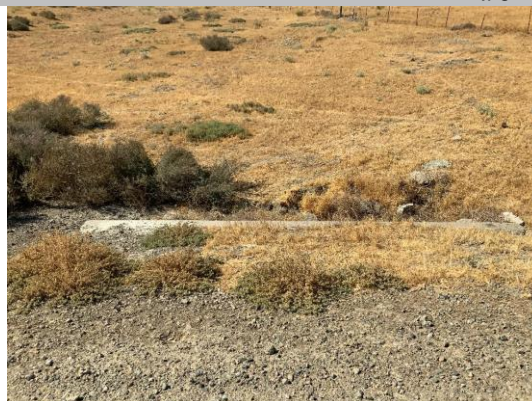
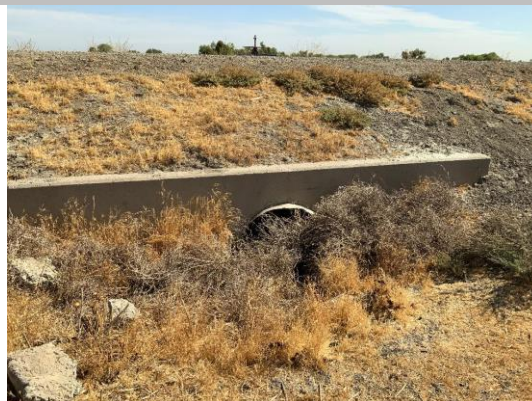
DS\_ID:19825  
FS\_ID:69953  
EP\_NO: N/A  
Repair Type: Non-Urgent  
EVAL Issue: Safety Issue  
Crossing Status: Found  
UCIP Comments: 07/27/2021 The record remains Non-Urgent. DWR DMP internal inspection has found pipe integrity issues. LOF of crossing is between 4.1 and 5. Crossing will be monitored until funding becomes available for rehabilitation. WS riser has broken cover, creating a safety hazard. Limited inspection due to dense tumbleweeds over LS inlet, recommend removal. No permit was found authorizing this encroachment. CVFPB will need to review crossing to determine owner. The UCIP inspection was completed with GEI staff, P. Espinoza. (H. Dunn – GEI) 04/18/2014 Sediment buildup inside pipe visible from landward side. Excess soil is also present on landward toe partially blocking concrete headwall and inlet. Recommend removing soil from landward toe and clear buildup inside. (O. Magana - DWR UCIP)

Levee crown.

LS view: Headwall visible at toe from crown.

LS view: Headwall and slope from toe.

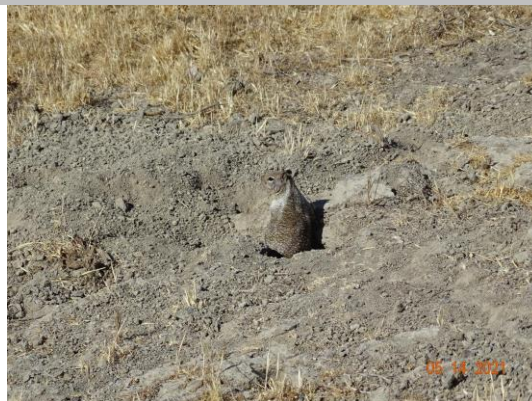
Photo 1 of 1 : FA\_2021\_NA0010\_124\_67\_20210830\_00007.jpg

LM Start	3.49	Rating **	M	Issue No.	67
LM End	3.49	Issue Type +	Ma	Location *	LS
Category	Earthen Levee			GPS Latitude/Longitude	
				Start	End
Item	Animal Control			37.251602 °	37.251602 °
				-120.778118 °	-120.778118 °
DWR ID	DWR_NA0010_06_f_2017_67				
Comment Code					
A1 : Exterminate rodents and backfill and compact or grout burrows.					
Inspector Comment

View of active rodent and burrow on the landside slope. (Spring 2021)

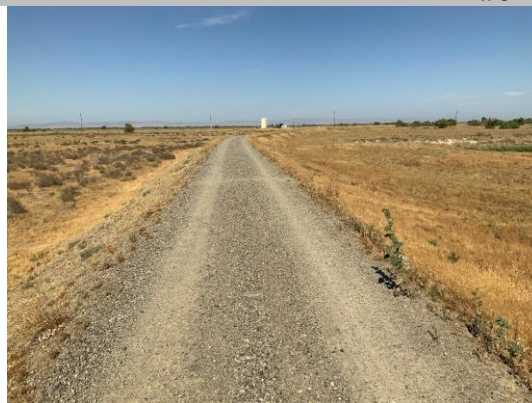
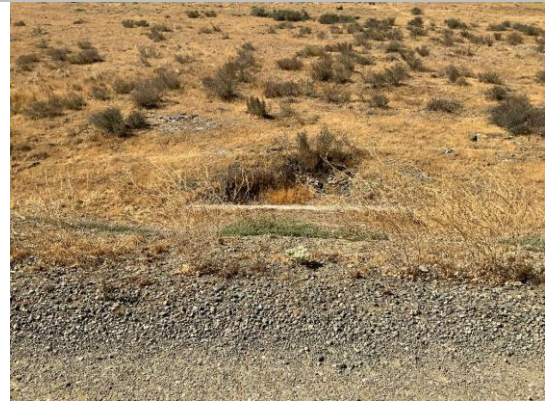
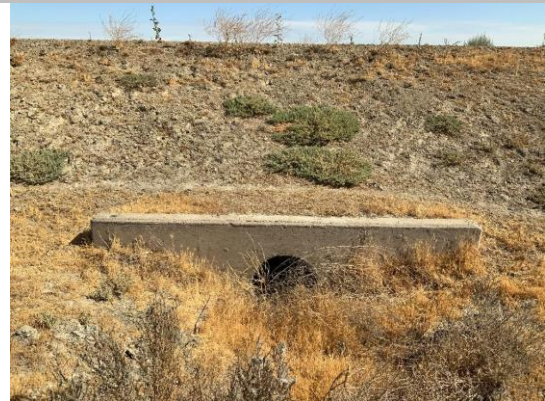
Comment Code					
Inspector Comment					
DS_ID:19826 FS_ID:69954 EP_NO: N/A Repair Type: Non-Urgent EVAL Issue: Pipe Damage Crossing Status: Found UCIP Comments: 07/27/2021 The record remains Non-Urgent. DWR DMP internal inspection has found pipe integrity issues. LOF of crossing is between 4.1 and 5. Crossing will be monitored until funding becomes available for rehabilitation. Limited inspection of LS pipe inlet due to vegetation covering it, recommend removal. Exterior liner of WS flapgate is significantly chipping off. No permit was found authorizing this encroachment. CVFPB will need to review crossing to determine owner. The UCIP inspection was completed with GEI staff, P. Espinoza. (H. Dunn – GEI) 04/18/2014 Sediment buildup inside crossing and is visible from landward side. Recommend clearing sediment buildup inside pipe and check wall integrity to determine condition. (O. Magana - DWR UCIP) FIELD_STRUCT_DESC: 24-inch corrugated metal gravity drainage pipe through the levee, 7 feet below the crown. Flap gate on the waterside (WS) end. Concrete headwall on each end. [Additional Reference(s): DWR Levee Log, 2002 (HLM 3.78), listed as a 24-inch corrugated metal pipe (CMP). USACE San Joaquin O&M Manual, Unit 601 Part 1 (SRJ601.1), 1967, Revised 25 May 2011, (HLM 3.77), listed as a 24-inch CMP] FS Date: 7/27/2021

Levee crown.

LS view: Headwall visible at toe from crown.

LS view: Headwall and slope from toe.

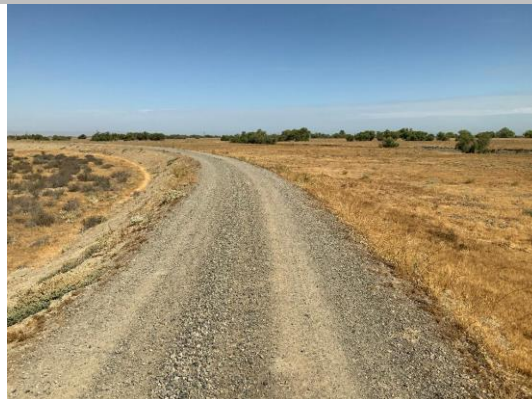
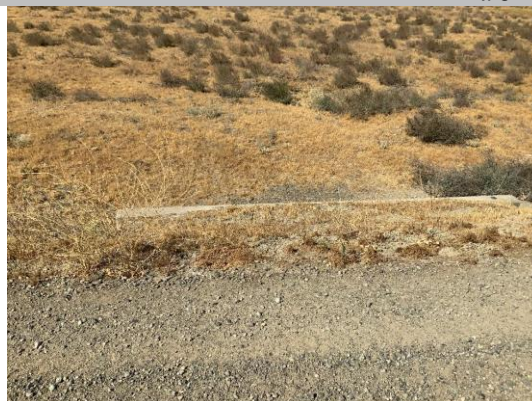
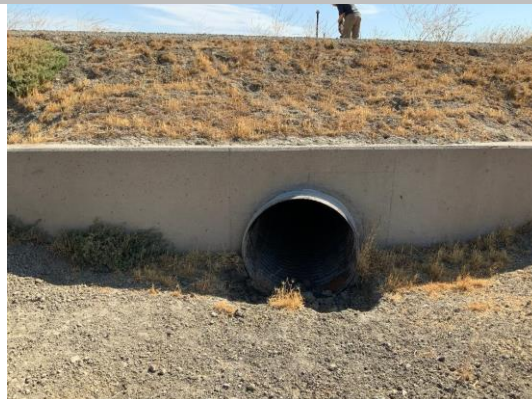
DS\_ID:19827  
FS\_ID:68740  
EP\_NO: N/A  
Repair Type: Non-Urgent  
EVAL Issue: Pipe Damage  
Crossing Status: Found  
UCIP Comments: 07/27/2021 The record remains Non-Urgent. DWR DMP internal inspection has found pipe integrity issues. LOF of crossing is between 4.1 and 5. Crossing will be monitored until funding becomes available for rehabilitation. No permit was found authorizing this encroachment. CVFPB will need to review crossing to determine owner. The UCIP inspection was completed with GEI staff, P. Espinoza. (H. Dunn – GEI) 04/18/2014 Sediment buildup inside crossing and is visible from landward side. Recommend clearing sediment buildup inside pipe and check wall integrity to determine condition. (O. Magana - DWR UCIP)  
FIELD\_STRUCT\_DESC: 36-inch corrugated metal gravity drainage pipe through the levee, 6.7 feet below the crown. Slide gate in a 48-inch corrugated metal pipe (CMP) riser on the waterside (WS) slope.

Levee crown.

LS view: Headwall visible at toe from crown.

LS view: Headwall and slope from toe.

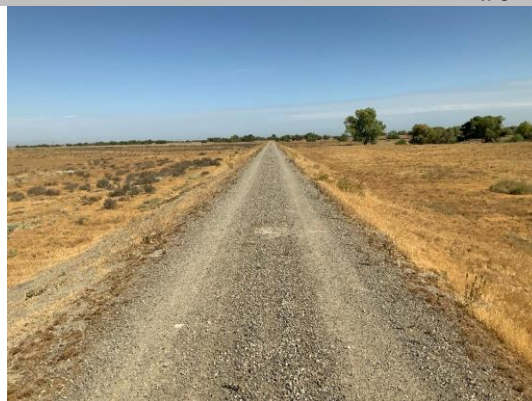
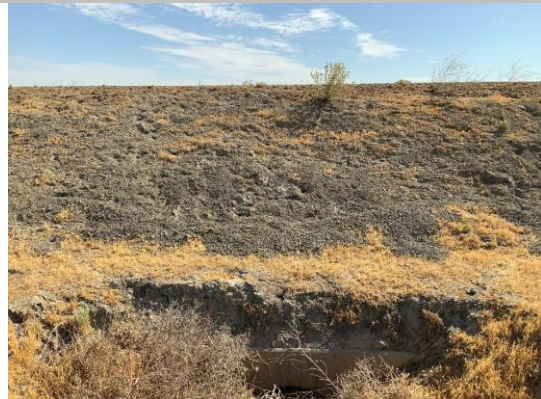
DS\_ID:19828  
 FS\_ID:69799  
 EP\_NO: N/A  
 Repair Type: Non-Urgent  
 EVAL Issue: Limited Inspection/No UCIP Evaluation  
 Crossing Status: Found  
 UCIP Comments: 07/27/2021 The record remains Non-Urgent. Limited inspection due to LS pipe inlet being covered by dense tumbleweeds, recommend removal. No permit was found authorizing this encroachment. CVFPB will need to review crossing to determine owner. The UCIP inspection was completed with GEI staff, P. Espinoza. (H. Dunn – GEI) 04/18/2014 Dense vegetation limits the inspector's visibility to identify signs of pipe condition on landward toe--headwall blocked by dense vegetation. Recommend removing vegetation from landward toe. (O. Magana - DWR UCIP)  
 FIELD\_STRUCT\_DESC: 24-inch corrugated metal gravity drainage pipe through the levee, 10.8 feet below the crown. Flap gate on the waterside (WS) end. Concrete headwall on each end. [Additional Reference(s): DWR Levee Log, 2002 (HLM 4.17), listed as a 24-inch corrugated metal pipe (CMP). USACE San Joaquin O&M Manual, Unit 601 Part 1 (SRJ601.1), 1967, Revised 25 May 2011, (HLM 4.17), listed as a 24-inch CMP]

Levee crown.

LS view: Toe from crown.

LS view: Slope from toe.

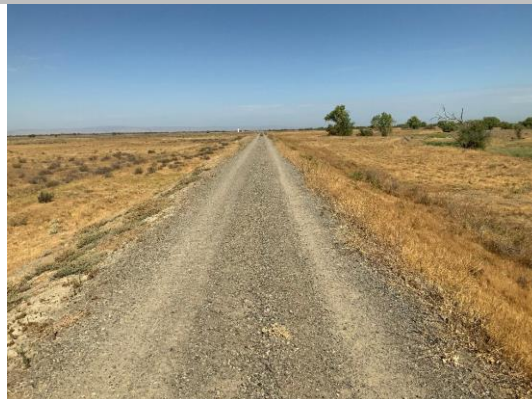
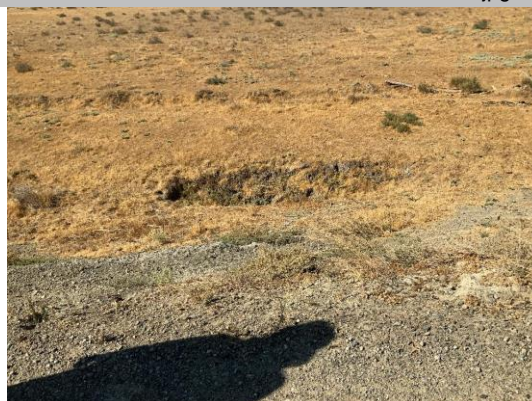
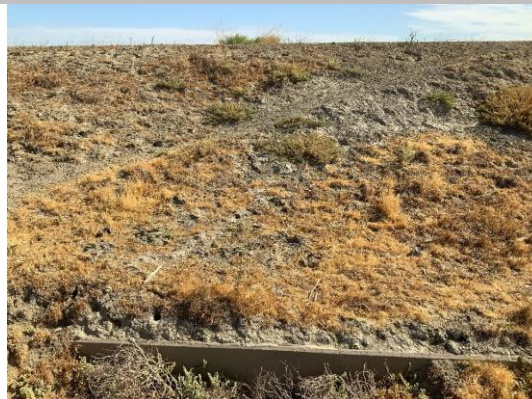
Comment Code						
Inspector Comment						
DS_ID:19829 FS_ID:69800 EP_NO: N/A Repair Type: Non-Urgent EVAL Issue: Pipe Damage Crossing Status: Found UCIP Comments: 07/27/2021 The record remains Non-Urgent. DWR DMP internal inspection has found pipe integrity issues. LOF of crossing is between 4.1 and 5. Crossing will be monitored until funding becomes available for rehabilitation. Limited inspection due to LS pipe inlet having some vegetation overgrowth over it, recommend removal. No permit was found authorizing this encroachment. CVFPB will need to review crossing to determine owner. The UCIP inspection was completed with GEI staff, P. Espinoza. (H. Dunn – GEI) 04/18/2014 Dense vegetation limits the inspector's visibility to identify signs of pipe condition on landward toe--headwall blocked by dense vegetation. Recommend removing vegetation from landward toe. (O. Magana - DWR UCIP) FIELD_STRUCT_DESC: 24-inch corrugated metal gravity drainage pipe through the levee, 11.3 feet below the crown. Flap gate on the waterside (WS) end. Concrete headwall on each end. [Additional Reference(s): DWR Levee Log, 2002 (HLM 4.43), listed as a 24-inch corrugated metal pipe (CMP). USACE San Joaquin O&M Manual, Unit 601 Part 1 (SRJ601.1), 1967, Revised 25 May 2011, (HLM 4.41), listed as a 24-inch CMP] FS Date: 7/27/2021

Levee crown.

LS view: Toe from crown.

LS view: Headwall and slope from toe.

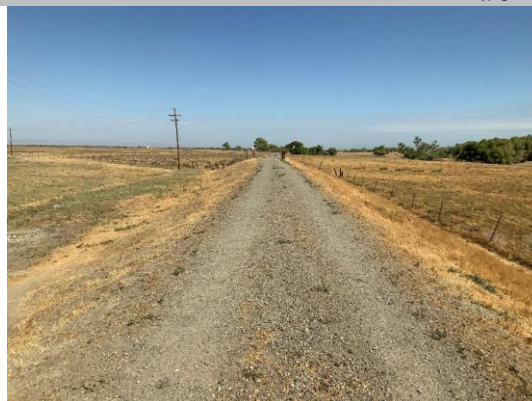
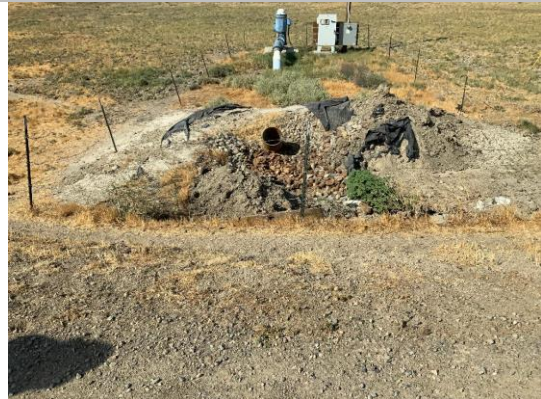
DS\_ID:19830  
 FS\_ID:69955  
 EP\_NO: N/A  
 Repair Type: Non-Urgent  
 EVAL Issue: Safety Issue  
 Crossing Status: Found  
 UCIP Comments: 07/27/2021 The record remains Non-Urgent. WS riser has no cover, causing safety hazard. Limited inspection due to LS pipe inlet completely buried within large dirt pile, recommend clearing out. No permit was found authorizing this encroachment. CVFPB will need to review crossing to determine owner. The UCIP inspection was completed with GEI staff, P. Espinoza. (H. Dunn – GEI) 04/18/2014  
 Sediment buildup inside crossing visible from landward side.  
 Recommend clearing sediment buildup inside pipe and check wall integrity to determine condition. (O. Magana - DWR UCIP)  
 FIELD\_STRUCT\_DESC: 36-inch corrugated metal gravity drainage pipe through the levee, 6.9 feet below the crown. Slide gate in a 48-inch corrugated metal pipe (CMP) riser on the waterside (WS) slope.

Concrete headwall on the landside (LS) end. Concrete saddle and apron on the WS end. [Additional Reference(s): DWR Levee Log, 2002 (HLM 4.69), listed as a 36-inch corrugated metal pipe (CMP). USACE San Joaquin O&M Manual, Unit 601 Part 1 (SRJ601.1), 1967, Revised 25 May 2011, (HLM 4.70), listed as a 36-inch CMP]  
 FS Date: 7/27/2021

Levee crown.

LS view: Toe from crown.

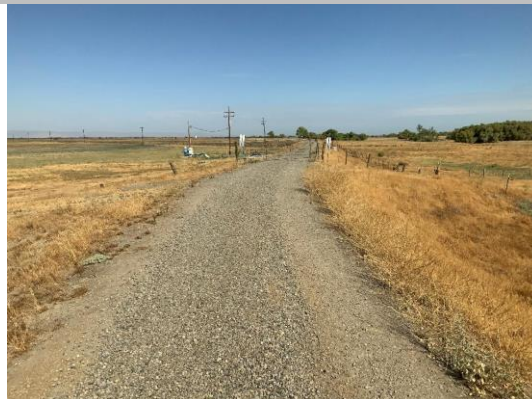
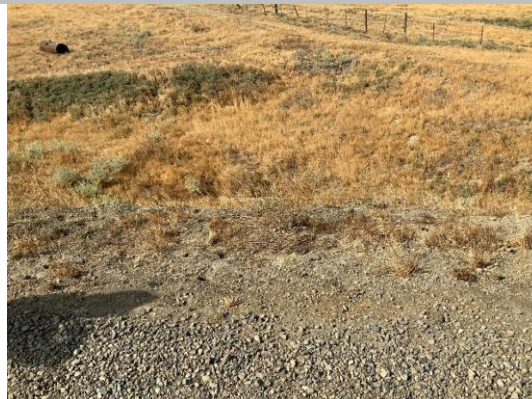
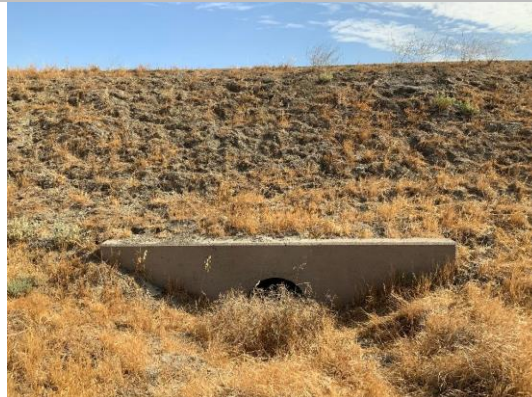
DS\_ID:19831  
FS\_ID:69956  
EP\_NO: N/A  
Repair Type: Urgent  
EVAL Issue: Pipe Integrity  
Crossing Status: Found  
UCIP Comments: 07/27/2021 The record has been upgraded from Non-Urgent to Urgent. DWR DMP internal inspection has found pipe integrity issues. LOF of crossing is greater than or equal to 5. Crossing will be monitored until funding becomes available to address the issues. Vegetation over LS pipe inlet, recommend removal. No permit was found authorizing this encroachment. CVFPB will need to review crossing to determine owner. The UCIP inspection was completed with GEI staff, P. Espinoza. (H. Dunn – GEI)04/18/2014 Need to contact owner. Recommend removing tall grass on landward toe to determine condition of crossing from landward side. (O. Magana - DWR UCIP)  
FIELD\_STRUCT\_DESC: 24-inch corrugated metal gravity drainage pipe through the levee, 11.8 feet below the crown. Flap gate on the waterside (WS) end. Concrete headwall on each end. [Additional Reference(s): DWR Levee Log, 2002 (HLM 4.75), listed as a 24-inch corrugated metal pipe (CMP). USACE San Joaquin O&M Manual, Unit 601 Part 1 (SRJ601.1), 1967, Revised 25 May 2011, (HLM 4.75), listed as a 24-inch CMP]

Levee crown.

LS view: Toe from crown.

LS view: Headwall and slope from toe.

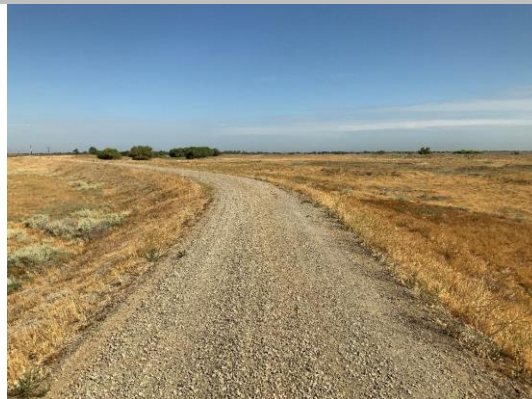
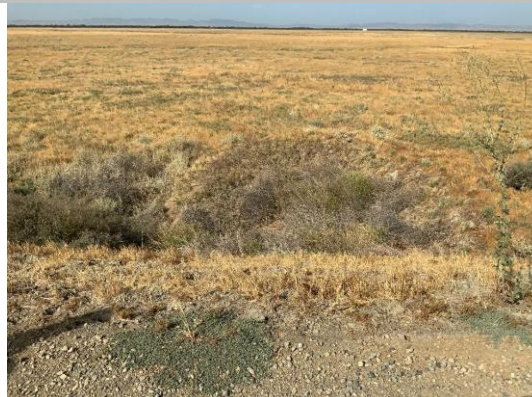
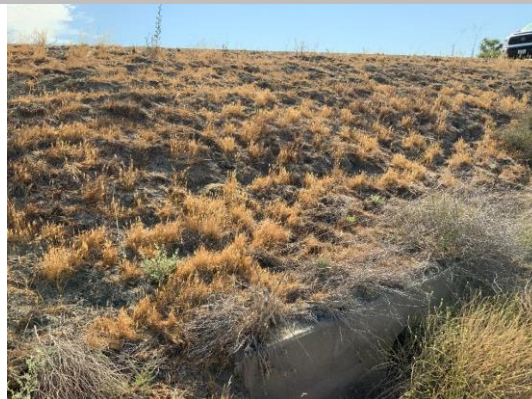
DS\_ID:19862  
FS\_ID:69802  
EP\_NO: N/A  
Repair Type: Non-Urgent  
EVAL Issue: Pipe Damage  
Crossing Status: Found  
UCIP Comments: 07/27/2021 The record remains Non-Urgent. DWR DMP internal inspection has found pipe integrity issues. LOF of crossing is between 4.1 and 5. Crossing will be monitored until funding becomes available for rehabilitation. Limited inspection due to dense vegetation over LS pipe inlet, recommend removal. No permit was found authorizing this encroachment. CVFPB will need to review crossing to determine owner. The UCIP inspection was completed with GEI staff, P. Espinoza. (H. Dunn – GEI) 04/18/2014 Dense vegetation limits the inspector's visibility to identify signs of pipe failure (leaks) along the waterward slope. Recommend removing vegetation along waterward slope to conduct proper inspection of structure. Also recommend removing dense vegetation blocking landward headwall. (O. Magana - DWR UCIP)

Levee crown.

LS view: Toe from crown.

LS view: Headwall and slope from toe.

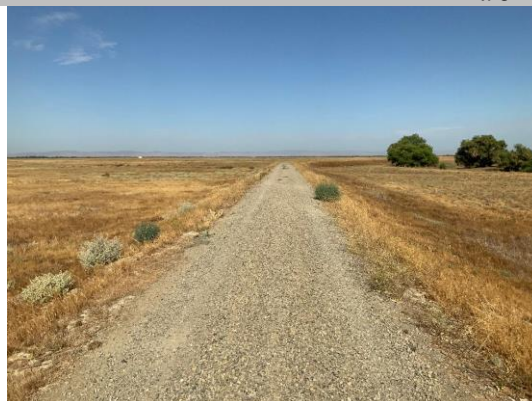
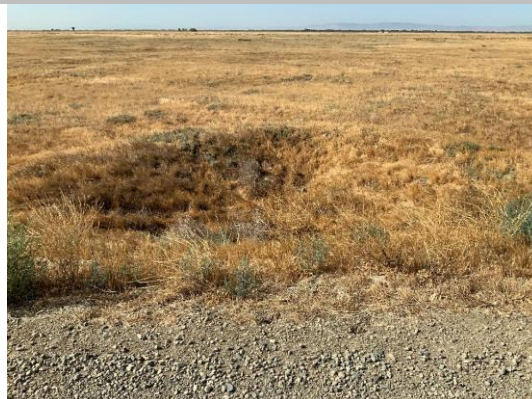
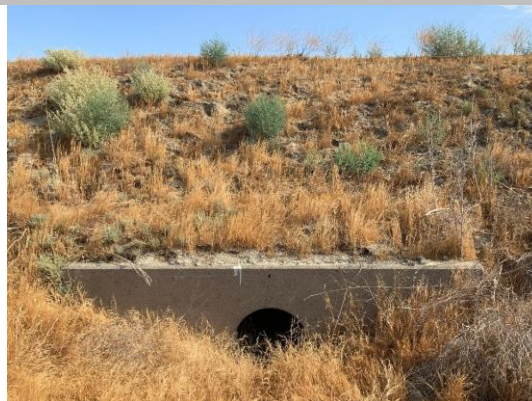
DS\_ID:19863  
 FS\_ID:69957  
 EP\_NO: N/A  
 Repair Type: Non-Urgent  
 EVAL Issue: Pipe Damage  
 Crossing Status: Found  
 UCIP Comments: 07/27/2021 The record remains Non-Urgent. DWR DMP internal inspection has found pipe integrity issues. LOF of crossing is greater than or equal to 4.1 and less than 5. Crossing will be monitored until funding becomes available for rehabilitation. No permit was found authorizing this encroachment. CVFPB will need to review crossing to determine owner. The UCIP inspection was completed with GEI staff, P. Espinoza. (H. Dunn – GEI) 04/18/2014 Clear vegetation from waterward slope and landward headwall. (O. Magana - DWR UCIP)  
 FIELD\_STRUCT\_DESC: 24-inch corrugated metal gravity drainage pipe through the levee, 10.9 feet below the crown. Flap gate on the waterside (WS) end. Concrete headwall on each end. [Additional Reference(s): DWR Levee Log, 2002 (HLM 5.35), listed as a 24-inch corrugated metal pipe (CMP). USACE San Joaquin O&M Manual, Unit 601 Part 1 (SRJ601.1), 1967, Revised 25 May 2011, (HLM 5.34), listed as a 24-inch CMP]

Levee crown.

LS view: Toe from crown.

LS view: Headwall and slope from toe.

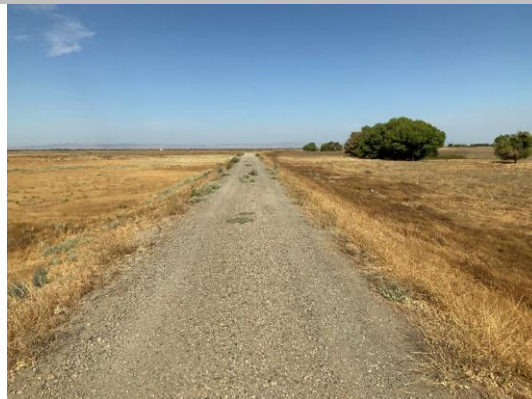
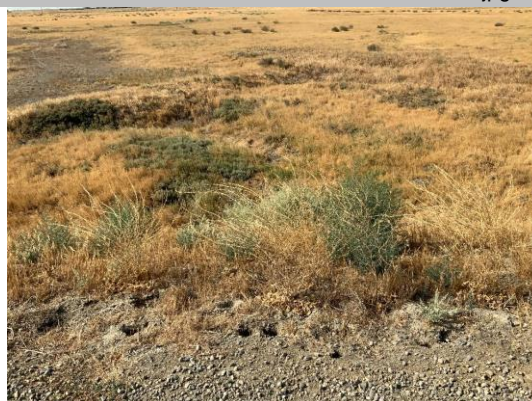
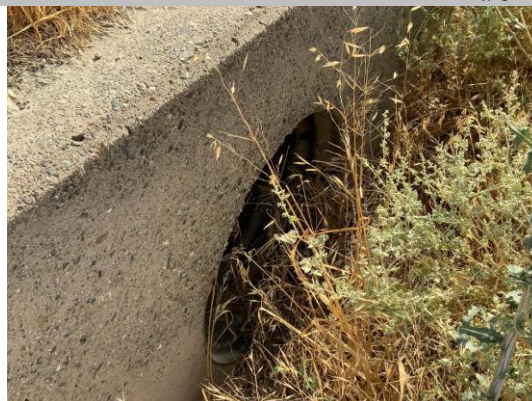
DS\_ID:19864  
FS\_ID:69803  
EP\_NO: N/A  
Repair Type: Non-Urgent  
EVAL Issue: Limited Inspection/No UCIP Evaluation  
Crossing Status: Found  
UCIP Comments: 07/27/2021 The record remains Non-Urgent. DWR DMP internal inspection has not found pipe integrity issues. LOF of crossing is less or equal to 4.0. Recommend next video inspection in 5 years. Limited inspection due to vegetation over LS pipe inlet, recommend removal. No permit was found authorizing this encroachment. CVFPB will need to review crossing to determine owner. The UCIP inspection was completed with GEI staff, P. Espinoza. (H. Dunn – GEI) 04/18/2014 Dense vegetation limits the inspector's visibility to identify signs of pipe failure (leaks) along the waterward slope. Recommend removing vegetation along pipe alignment to conduct proper inspection of structure. Also recommend removing excess vegetation at landward headwall. (O. Magana - DWR UCIP)

Levee crown.

LS view: Toe from crown.

LS view: Closeup of pipe inlet at toe with vegetation growth.

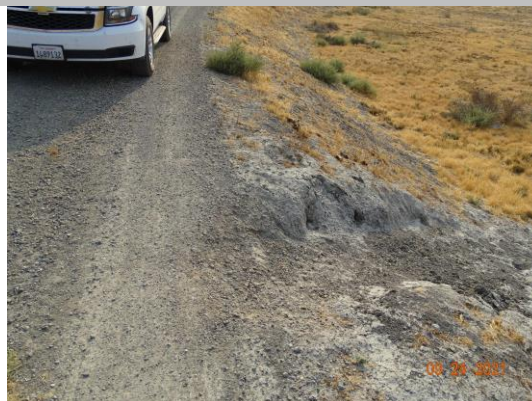
LM Start	5.77	Rating **	U	Issue No.	66
LM End	5.77	Issue Type +	Ma	Location *	LS
Category	Earthen Levee			GPS Latitude/Longitude	
				Start	End
Item	Animal Control			37.238354 °	37.238354 °
				-120.742480 °	-120.742480 °
DWR ID	DWR_NA0010_06_f _ 2017_66				
Comment Code					
A2 : Repair the levee slope damaged by livestock and prevent large animal access.					
Inspector Comment					
There is damage to the landside slope and shoulder from livestock.

View of damage to landside slope from livestock traffic looking downstream. (Fall 2021)

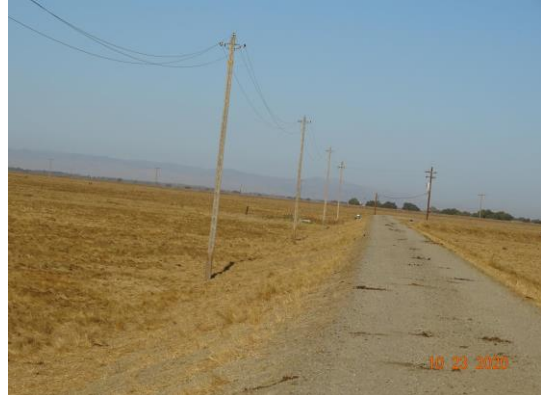
LM Start	5.93	Rating **	M	Issue No.	69
LM End	7.09	Issue Type +	En	Location *	LS
Category	Earthen Levee			GPS Latitude/Longitude	
				Start	End
Item	Encroachments			37.236936 °	37.226800 °
				-120.740384 °	-120.724736 °
DWR ID	DWR_NA0010_06_f_2015_69				
Comment Code					
PO : Pole					
Inspector Comment					
There are several PG&E poles within this section at the landside toe and slope.

Looking downstream at PG&E poles on the landside slope and toe. (Fall 2020)

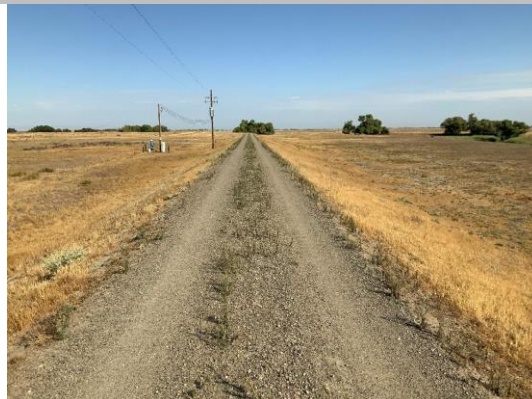
Comment Code					
Inspector Comment					
DS_ID:19865 FS_ID:70009 EP_NO: N/A Repair Type: Non-Urgent EVAL Issue: Unauthorized Encroachment, installed decades prior Crossing Status: Found UCIP Comments: 07/27/2021 The record has been upgraded from No Action Needed to Non-Urgent. No permit was found authorizing this encroachment. CVFPB will need to review crossing to determine owner. Crossing appears to be in good condition. Separate 10 inch plastic pipe inlet and flowmeter off the LS toe across this Crossing's inlet. The UCIP inspection was completed with GEI staff, P. Espinoza. (H. Dunn – GEI)  7/19/2016 Site has been repaired on WS and LS (see photos below). (O. Magana - DWR UCIP)5/26/2016 Erosion is undermining the WS headwall of drainage structure (photos of WS headwall provided by DWR Inspector R. Willoughby). Potential pipe failure at the outlet just behind headwall, recommend completing internal wall integrity of pipe length through levee to determine extent of damage to pipe. (O. Magana - DWR UCIP)4/18/2014 Need to contact owner. Sediment buildup in pipe visible on landside--recommend clearing. (O. Magana - DWR UCIP) FIELD_STRUCT_DESC: 24-inch corrugated metal gravity drainage pipe through the levee, 9 feet below the crown. Flap gate on the waterside (WS) end. Concrete headwall on each end. [Additional Reference(s): DWR Levee Log, 2002 (HLM 6.06), listed as a 24-inch corrugated metal pipe (CMP). USACE San Joaquin O&M Manual, Unit 601 Part 1 (SRJ601.1), 1967, Revised 25 May 2011, (HLM 6.06), listed as a 24-inch CMP] FS Date: 7/27/2021

Levee crown.

LS view: Toe from crown.

LS toe: Headwall and slope from toe.

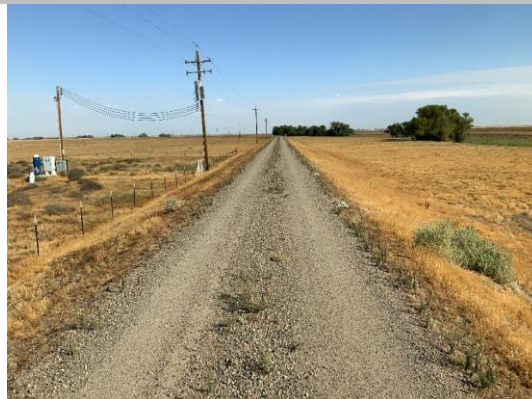
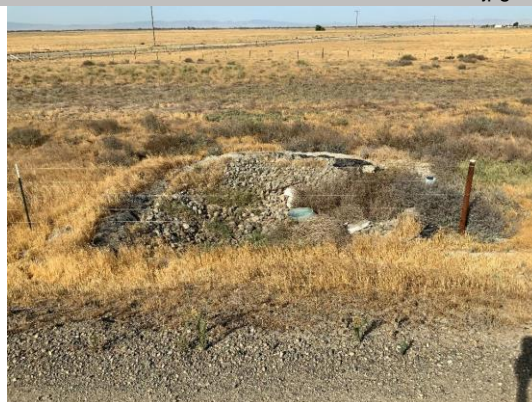
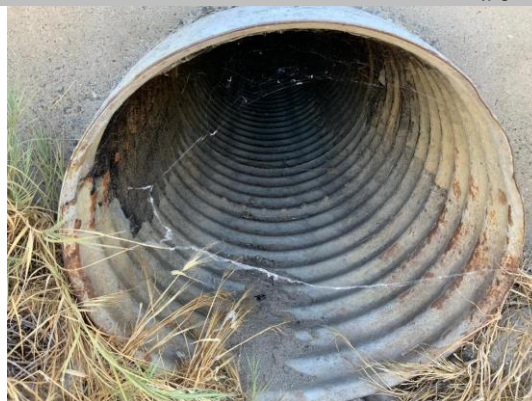
DS\_ID:19866  
FS\_ID:69959  
EP\_NO: N/A  
Repair Type: Non-Urgent  
EVAL Issue: Unauthorized Encroachment, installed decades prior  
Crossing Status: Found  
UCIP Comments: 07/27/2021 The record has been upgraded from No Action Needed to Non-Urgent. Crossing appears to be in good condition. No permit was found authorizing this encroachment. CVFPB will need to review crossing to determine owner. The UCIP inspection was completed with GEI staff, P. Espinoza. (H. Dunn – GEI)  
FIELD\_STRUCT\_DESC: 24-inch corrugated metal gravity drainage pipe through the levee, 7 feet below the crown. Slide gate in a 36-inch corrugated metal pipe (CMP) riser on the waterside (WS) slope. Concrete headwall on the landside (LS) end. Concrete saddle and apron on the WS end. [Additional Reference(s): DWR Levee Log, 2002 (HLM 6.78), listed as a 24-inch corrugated metal pipe (CMP). USACE San Joaquin O&M Manual, Unit 601 Part 1 (SRJ601.1), 1967, Revised 25 May 2011, (HLM 6.79), listed as a 24-inch CMP]

Levee crown.

LS view: Toe from crown.

LS view: Closeup of pipe inlet at toe.

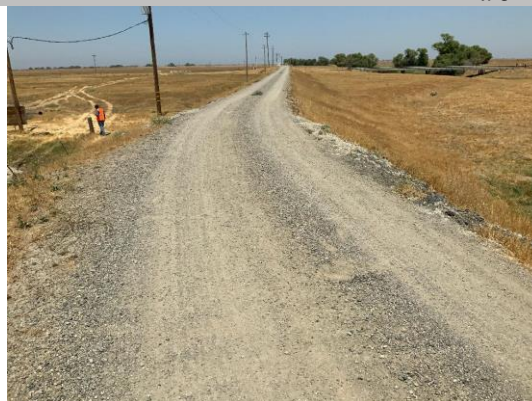
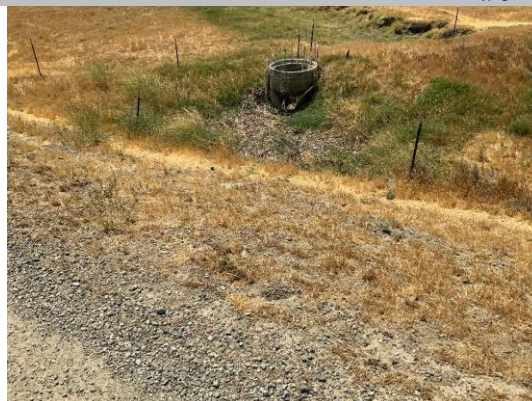
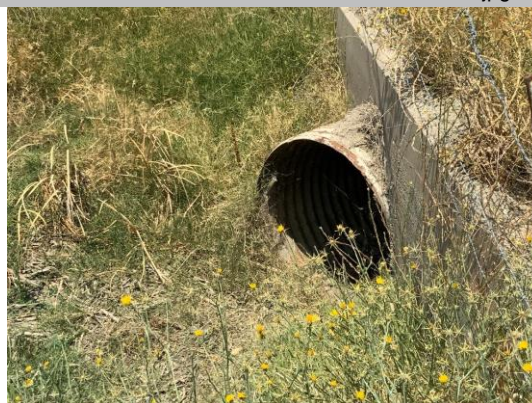
Photo 1 of 3 : UCIP\_FA\_2021\_69960\_101625.jpg

DS\_ID:19867  
 FS\_ID:69960  
 EP\_NO: N/A  
 Repair Type: Non-Urgent  
 EVAL Issue: Safety Issue  
 Crossing Status: Found  
 UCIP Comments: 07/13/2021 The record has been upgraded from No Action Needed to Non-Urgent. The cover on the WS riser is broken, causing a safety concern. There is another riser, pump, and pipe out closer to the channel on the WS but is not within 15 feet of the toe. No permit was found authorizing this encroachment. CVFPB will need to review crossing to determine owner. The UCIP inspection was completed with GEI staff, P. Espinoza. (H. Dunn – GEI)  
 FIELD\_STRUCT\_DESC: 36-inch corrugated metal gravity drainage pipe through the levee, 10.7 feet below the crown. Slide gate in a 48-inch corrugated metal pipe (CMP) riser on the waterside (WS) slope. Concrete headwall on the landside (LS) end. Concrete U-shaped headwall on the WS end. [Additional Reference(s): DWR Levee Log, 2002 (HLM 6.97), listed as a 36-inch corrugated metal pipe (CMP). USACE San Joaquin O&M Manual, Unit 601 Part 1 (SRJ601.1), 1967, Revised 25 May 2011, (HLM 6.97), listed as a 36-inch CMP]

Levee crown.

LS view: Toe from crown.

LS view: Closeup of pipe inlet at toe.

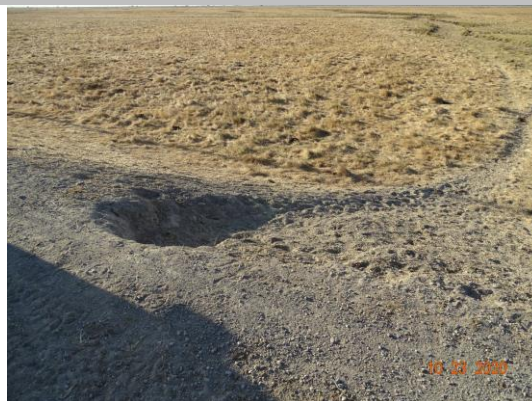
Photo 1 of 1 : FA\_2021\_NA0010\_124\_79\_20210830\_00015.jpg

LM Start	6.92	Rating **	A/W	Issue No.	79
LM End	6.92	Issue Type +	Ma	Location *	LS
Category	Earthen Levee			GPS Latitude/Longitude	
				Start	End
Item	Animal Control			37.228054 °	37.228054 °
				-120.727428 °	-120.727428 °
DWR ID	DWR_NA0010_06_f _ 2018_79				
Comment Code					
A2 : Repair the levee slope damaged by livestock and prevent large animal access.					
Inspector Comment					
Slope damage has been repaired with loose soil. Monitor for settlement.

View down the landside slope of damage from livestock. (Fall 2020)

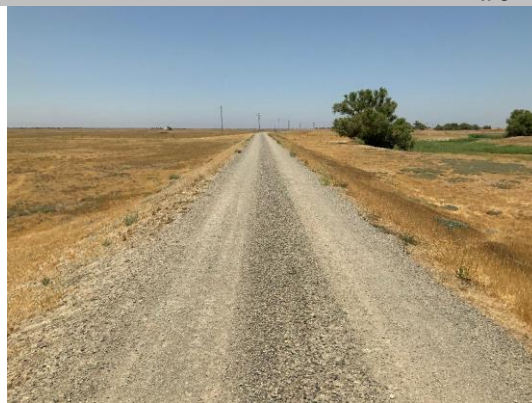
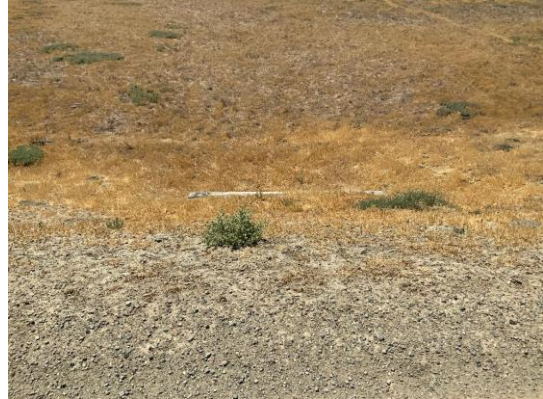
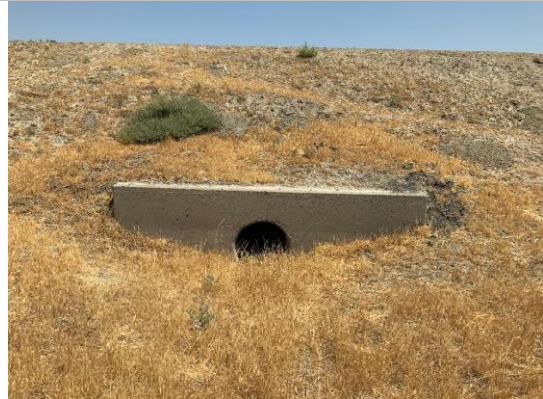
Photo 1 of 3 : UCIP\_FA\_2021\_68024\_101634.jpg

Comment Code						
Inspector Comment						
DS_ID:19868 FS_ID:68024 EP_NO: N/A Repair Type: Non-Urgent EVAL Issue: Pipe Damage Crossing Status: Found UCIP Comments: 07/13/2021 Record is still Non-Urgent. DWR DMP internal inspection has found pipe integrity issues. LOF of crossing is between 4.1 and 5. Crossing will be monitored until funding becomes available for rehabilitation. No permit was found authorizing this encroachment. CVFPB will need to review crossing to determine owner. The UCIP inspection was completed with GEI staff, P. Espinoza. (H. Dunn – GEI) 04/18/2014 Need to contact owner. Clear animal from waterward side. Some sediment buildup in pipe visible landward side-- recommend clearing. (O. Magana - DWR UCIP) FIELD_STRUCT_DESC: 24-inch corrugated metal gravity drainage pipe through the levee, 10.6 feet below the crown. Flap gate on the waterside (WS) end. Concrete headwall on each end. [Additional Reference(s): DWR Levee Log, 2002 (HLM 7.29), listed as a 24-inch corrugated metal pipe (CMP). USACE San Joaquin O&M Manual, Unit 601 Part 1 (SRJ601.1), 1967, Revised 25 May 2011, (HLM 7.29), listed as a 24-inch CMP] FS Date: 7/13/2021

Levee crown.

LS view: Headwall visible at toe from crown.

LS view: Slope and headwall at toe.

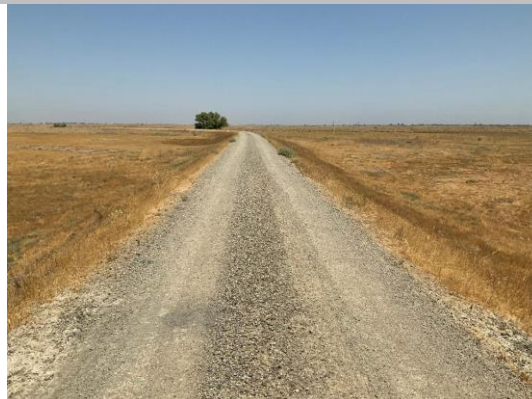
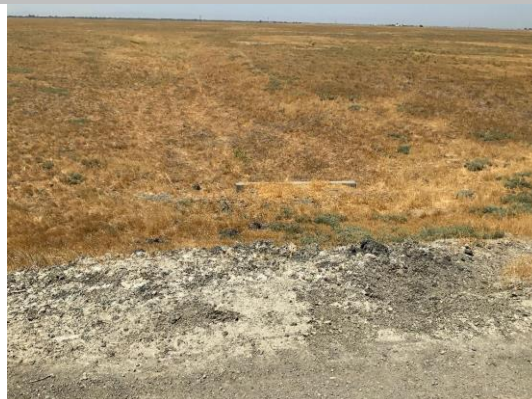
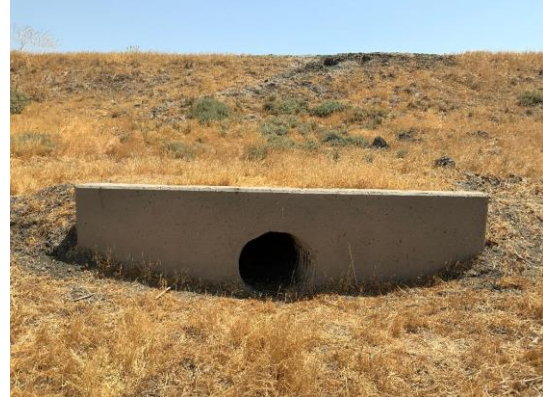
Photo 1 of 3 : UCIP\_FA\_2021\_69961\_101643.jpg

DS\_ID:19869  
FS\_ID:69961  
EP\_NO: N/A  
Repair Type: Non-Urgent  
EVAL Issue: Pipe Damage  
Crossing Status: Found  
UCIP Comments: 07/13/2021 Record remains Non-Urgent. DWR DMP internal inspection has found pipe integrity issues. LOF of crossing is greater than or equal to 4.1 and less than 5. Crossing will be monitored until funding becomes available for rehabilitation. No longer sediment buildup as mentioned in previous inspection. No permit was found authorizing this encroachment. CVFPB will need to review crossing to determine owner. The UCIP inspection was completed with GEI staff, P. Espinoza. (H. Dunn – GEI) 04/18/2014 Some sediment buildup in pipe visible on landward side--recommend clearing. (O. Magana - DWR UCIP)  
FIELD\_STRUCT\_DESC: 24-inch corrugated metal gravity drainage pipe through the levee, 11.8 feet below the crown. Flap gate on the waterside (WS) end. Concrete headwall on each end. Skewed crossing. [Additional Reference(s): DWR Levee Log, 2002 (HLM 7.74), listed as a 24-inch corrugated metal pipe (CMP). USACE San Joaquin O&M Manual, Unit 601 Part 1 (SRJ601.1), 1967, Revised 25 May 2011, (HLM 7.74), listed as a 24-inch CMP]

Levee crown.

LS view: Headwall visible at toe from crown.

LS view: Slope and headwall at toe.

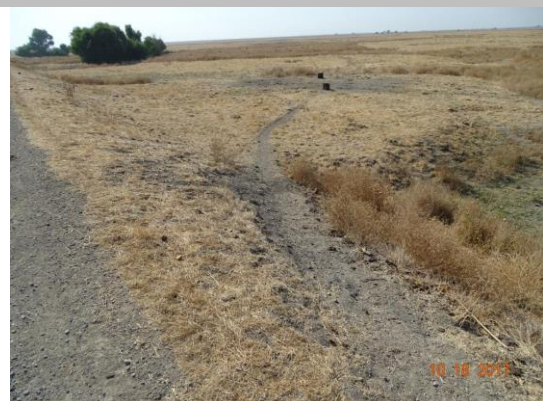
Photo 1 of 1 : FA\_2021\_NA0010\_124\_65\_20210830\_00005.jpg

LM Start	8.08	Rating **	A/W	Issue No.	65
LM End	8.08	Issue Type +	Ma	Location *	LS
Category	Earthen Levee			GPS Latitude/Longitude	
				Start	End
Item	Animal Control			37.217199 °	37.217199 °
				-120.713374 °	-120.713374 °
DWR ID	DWR_NA0010_06_f_2017_65				
Comment Code					
A2 : Repair the levee slope damaged by livestock and prevent large animal access.					
Inspector Comment					
Livestock damage to levee slope.

Looking southwest at the landside slope.

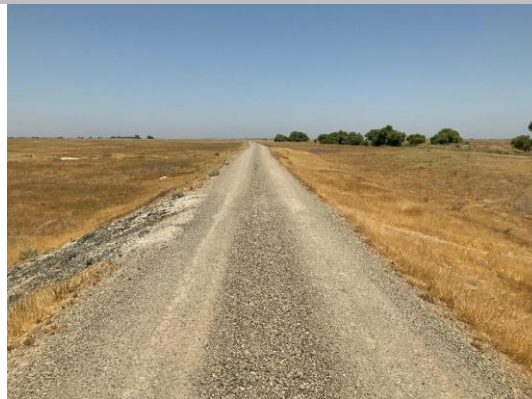
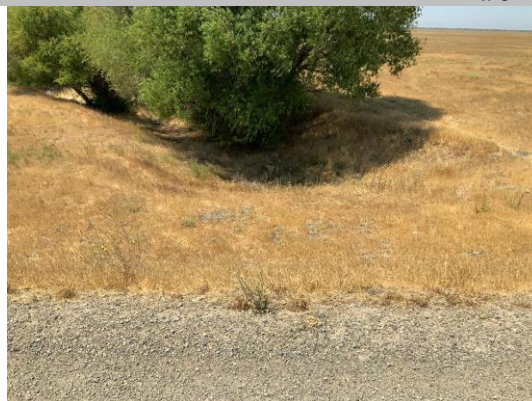
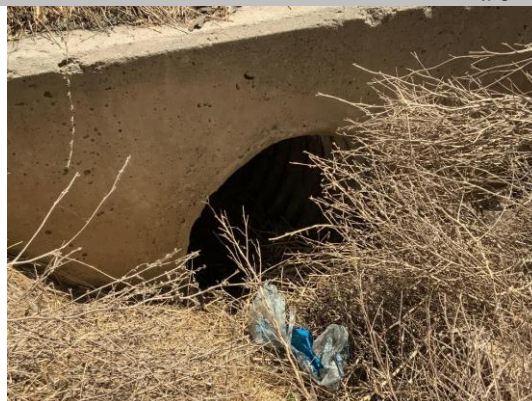
Photo 1 of 3 : UCIP\_FA\_2021\_69962\_102248.jpg

DS\_ID:19870  
FS\_ID:69962  
EP\_NO: N/A  
Repair Type: Non-Urgent  
EVAL Issue: Pipe Damage  
Crossing Status: Found  
UCIP Comments: 07/13/2021 Record remains Non-Urgent. DWR DMP internal inspection has found pipe integrity issues. LOF of crossing is greater than or equal to 4.1 and less than 5. Crossing will be monitored until funding becomes available for rehabilitation. Some vegetation buildup over LS pipe inlet and WS flapgate, recommend removal of vegetation on both ends. No permit was found authorizing this encroachment. CVFPB will need to review crossing to determine owner. The UCIP inspection was completed with GEI staff, P. Espinoza. (H. Dunn – GEI) 04/18/2014 Sediment buildup in pipe--recommend contacting owner to clear sediment. (O. Magana - DWR UCIP)  
FIELD\_STRUCT\_DESC: 24-inch corrugated metal gravity drainage pipe through the levee, 16.5 feet below the crown. Flap gate on the waterside (WS) end. Concrete headwall on each end. [Additional Reference(s): DWR Levee Log, 2002 (HLM 8.22), listed as a 24-inch corrugated metal pipe (CMP). USACE San Joaquin O&M Manual, Unit 601 Part 1 (SRJ601.1), 1967, Revised 25 May 2011, (HLM 8.21), listed as a 24-inch CMP]

Levee crown.

LS view: Toe from crown.

LS view: Closeup of pipe inlet at toe. Some vegetation blocking.

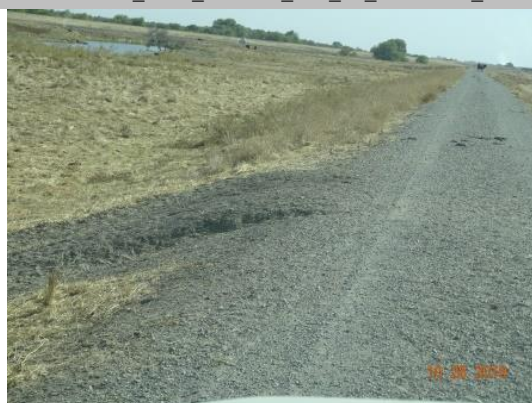
Photo 1 of 1 : FA\_2021\_NA0010\_124\_89\_20210830\_00022.jpg

LM Start	8.32	Rating **	A/W	Issue No.	89
LM End	8.32	Issue Type +	Ma	Location *	WS
Category	Earthen Levee			GPS Latitude/Longitude	
				Start	End
Item	Animal Control			37.214273 °	37.214273 °
				-120.711100 °	-120.711100 °
DWR ID	DWR_NA0010_06_f_2019_89				
Comment Code					
A2 : Repair the levee slope damaged by livestock and prevent large animal access.					
Inspector Comment					
Slope damage has been repaired with loose soil. Monitor for settlement.

View of damage to the waterside slope looking upstream. (Fall 2019)

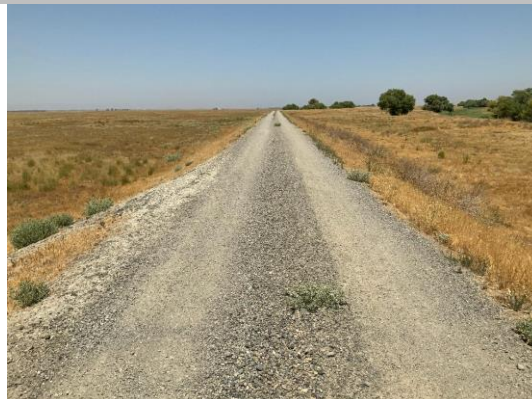
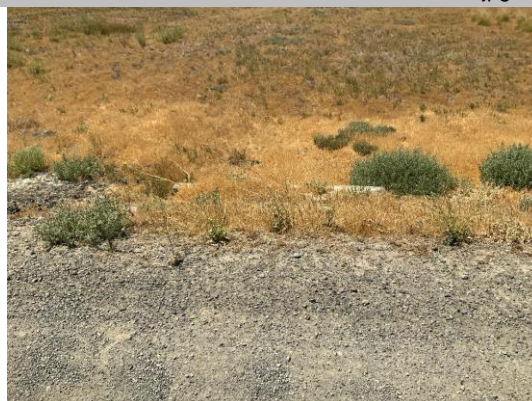
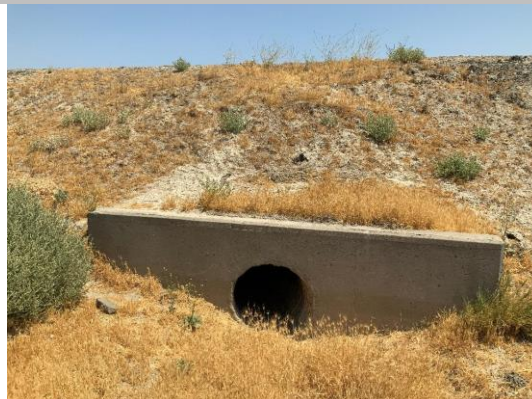
Photo 1 of 3 : UCIP\_FA\_2021\_68479\_102254.jpg

DS\_ID:19871  
FS\_ID:68479  
EP\_NO: N/A  
Repair Type: Non-Urgent  
EVAL Issue: Pipe Damage  
Crossing Status: Found  
UCIP Comments: 07/13/2021 Record remains Non-Urgent. DWR DMP internal inspection has found pipe integrity issues. LOF of crossing is between 4.1 and 5. Crossing will be monitored until funding becomes available for rehabilitation. Inside of LS pipe inlet is rusted but no visible holes or deterioration. No permit was found authorizing this encroachment. CVFPB will need to review crossing to determine owner. The UCIP inspection was completed with GEI staff, P. Espinoza. (H. Dunn – GEI) 04/18/2014 Need to contact owner. Sediment buildup in pipe visible on landward side--recommend clearing. Good candidate for pressure test or video inspection due to signs of heavy corrosion. If no leaks after tests this crossing would be a good candidate for rehabilitation. (O. Magana - DWR UCIP)

Levee crown.

LS view: Headwall visible at toe from crown.

LS view: Headwall and slope at toe.

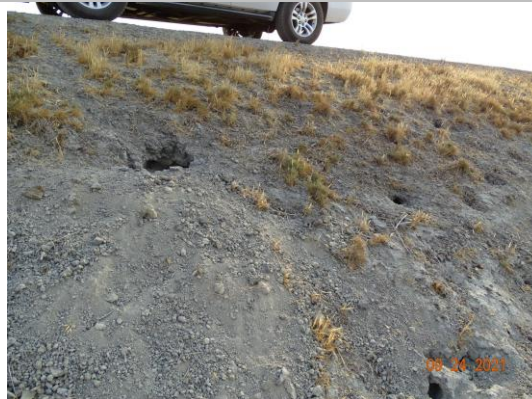
Photo 1 of 1 : FA\_2021\_NA0010\_124\_121\_20210929\_00217.jpg

LM Start	8.69	Rating **	M	Issue No.	121
LM End	8.69	Issue Type +	Ma	Location *	LS
Category	Earthen Levee			GPS Latitude/Longitude	
				Start	End
Item	Animal Control			37.210809 °	37.210809 °
				-120.706106 °	-120.706106 °
DWR ID	DWR_NA0010_06_f_2021_121				
Comment Code					
A3 : No rodents visible, but rodent burrows visible; need to backfill and compact or grout burrows.					
Inspector Comment

Looking at rodent holes in the landside slope. (Fall 2021)

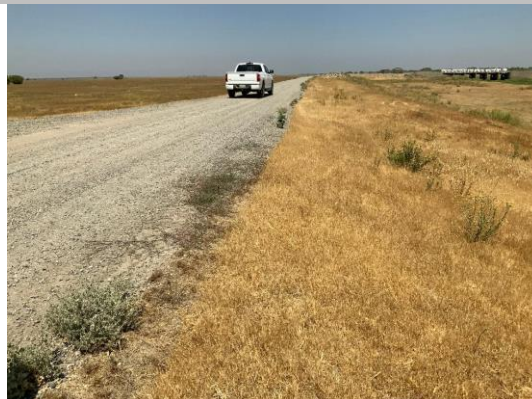
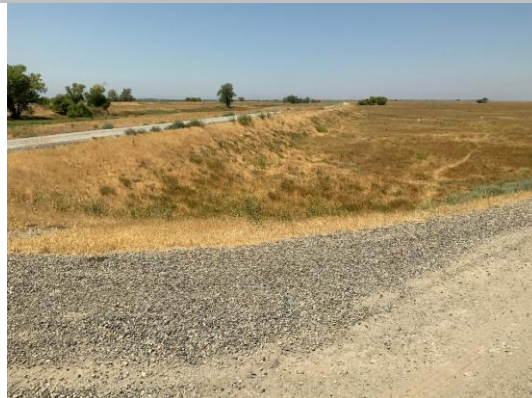
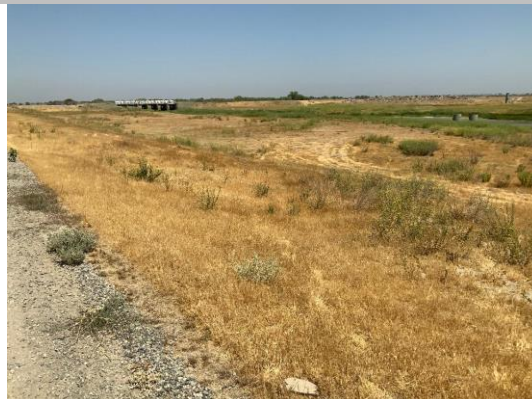
Photo 1 of 3 : UCIP\_FA\_2021\_68484\_102262.jpg

Comment Code					
Inspector Comment					
DS_ID:19872 FS_ID:68484 EP_NO: N/A Repair Type: Non-Urgent EVAL Issue: Pipe Not Found Crossing Status: Not Found UCIP Comments: 07/13/2021 The record remains Non-Urgent. Cable not found by visual inspection and no service box found. Recommend contacting owner to obtain status of this crossing and alignment. No permit was found authorizing this encroachment. CVFPB will need to review crossing to determine owner. The UCIP inspection was completed with GEI staff, P. Espinoza. (H. Dunn – GEI)12/05/2014 Accidently missed updating record. Photos have been added and coordinates have been updated. Unable to confirm if crossing is the same cable line originally identified in desk study at levee mile 9.43. Recommend contacting owner to confirm alignment, size of conduit, and permit issued. (O. Magana - DWR UCIP) FIELD_STRUCT_DESC: Telephone cable of an unknown size or material under crown of roadway, at an unknown depth. [Additional Reference(s): DWR Levee Log, 2002 (HLM 9.43), listed as a buried telephone cable] FS Date: 7/13/2021

Levee crown.

LS view: Top of slope, no box visible.

WS view: Slope from crown, no box visible.

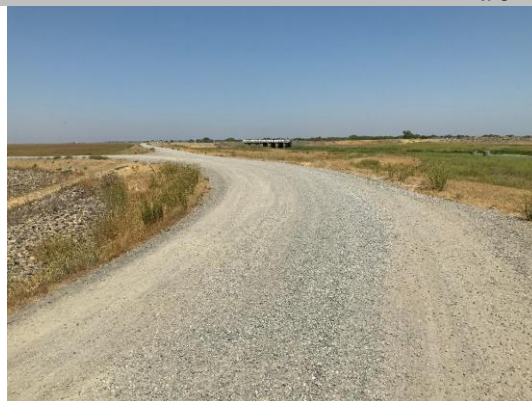
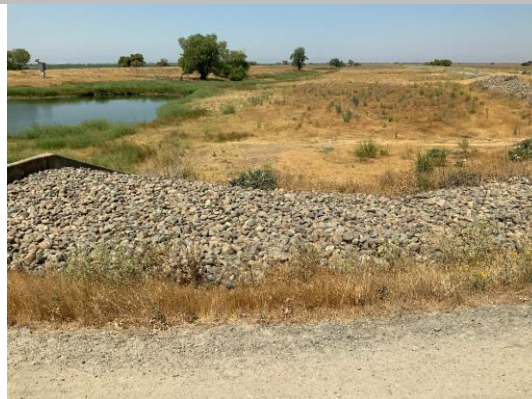
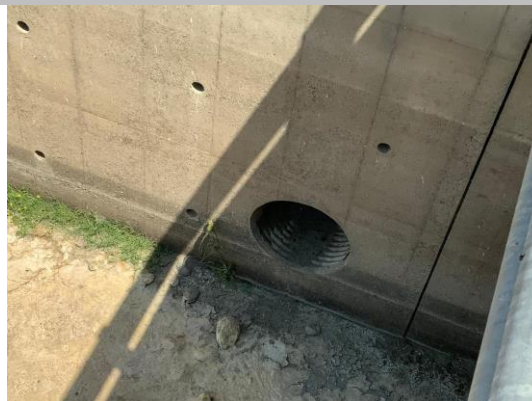
Photo 1 of 3 : UCIP\_FA\_2021\_68483\_102272.jpg

DS\_ID:19873  
 FS\_ID:68483  
 EP\_NO: N/A  
 Repair Type: Non-Urgent  
 EVAL Issue: Limited Inspection/No UCIP Evaluation  
 Crossing Status: Found  
 UCIP Comments: 07/13/2021 The record remains Non-Urgent.  
 Standing water on the WS at time of inspection, limited inspection. No permit was found authorizing this encroachment. CVFPB will need to review crossing to determine owner. The UCIP inspection was completed with GEI staff, P. Espinoza. (H. Dunn – GEI) 12/05/2014  
 Accidentally missed entry. Photos have been added and coordinates have been updated by Olivia Magana. Unable to determine condition of crossing due to limited access. Recommend contacting owner to provide condition of crossing. (O. Magana - DWR UCIP)  
 FIELD\_STRUCT\_DESC: 36-inch corrugated metal gravity drainage pipe through the levee, 14 feet below the crown. Slide gate in a concrete diversion box on the waterside (WS) shoulder. [Additional Reference(s): DWR Levee Log, 2002 (HLM 9.64), listed as a 36-inch corrugated metal pipe (CMP)].

Levee crown.

LS view: Toe from crown.

LS view: Pipe inlet at toe from bridge.

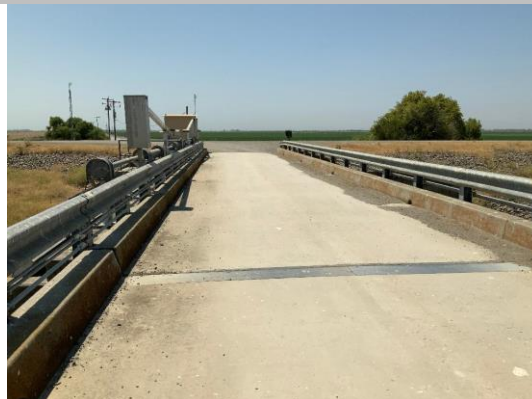
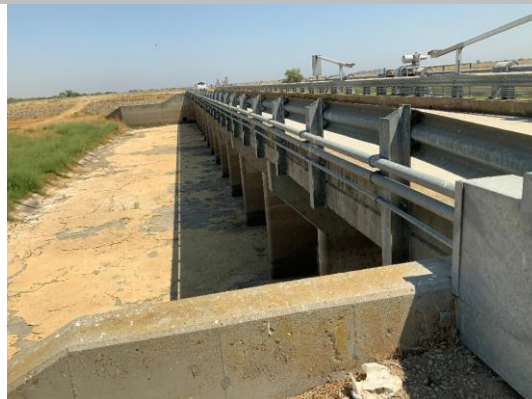
Photo 1 of 3 : UCIP\_FA\_2021\_68485\_102276.jpg

DS\_ID:19742  
FS\_ID:68485  
EP\_NO: N/A  
Repair Type: Non-Urgent  
EVAL Issue: Unauthorized Encroachment, installed decades prior  
Crossing Status: Found  
UCIP Comments: 07/13/2021 The record remains Non-Urgent. No permit was found authorizing this encroachment. CVFPB will need to review crossing to determine owner. Crossing appears in good condition. The UCIP inspection was completed with GEI staff, P. Espinoza. (H. Dunn – GEI) 10/27/2017 This structure is inspected annually under the Structure and Channel Summer Inspection (part of the Levee Inspection Program) conducted by the DWR Flood Project Integrity and Inspection Branch (FPIIB). (O. Magana - DWR UCIP) 04/21/2014 Accidentally missed--need photos (O. Magana - DWR UCIP) FIELD\_STRUCT\_DESC: [Mariposa Bypass Structure] Approximately 14 reinforced concrete box gravity drainage culverts of an unknown size across the intersection of the Mariposa Bypass and the Eastside Bypass. Roadway across structure. Controlled slide gates on end four culverts, both sides. Wing wall on each side of the structure. Rock revetment immediately downstream of the structure. [Additional Reference(s): DWR Levee Log, 2002 (HLM 9.64), listed as Mariposa Bypass Control Structure]

Top of bridge.

LS view: Inlet culverts along bridge at toe.
