## Flood Control Project Maintenance Levee Inspections

### Fall 2021 Levee Maintenance Deficiency Summary Report

#### San Joaquin River Basin

NA0010 Lower San Joaquin Levee District	Overall LMA Rating	Total LMA Miles							
	U	191.27							
Rated Item	Maintenance Deficiency				Enforcement		Design & System Obsolescence		
	M Miles	U Miles	M + 4U Miles	Threshold %	M Miles	U Miles	M Miles	U Miles	
<i>Earthen Levee</i>									
Vegetation	47.00	9.57	85.28	44.59%					
Trim / Thin Trees	0.10		0.10	0.05%					
Encroachments	0.23	0.02	0.31	0.16%	9.29	0.59			
Animal Control	7.67	2.19	16.43	8.59%					
Slope Stability	0.05	0.01	0.09	0.05%					
Erosion / Bank Caving	0.13	0.81	3.37	1.76%					
Crown Surface / Depressions / Rutting	0.01		0.01	0.01%					
Repair Gates	0.02	0.02	0.10	0.05%					
<i>Rivers, Channels &amp; Designated Floodways</i>									
Encroachments					0.01	0.01			
<i>Supplemental</i>									
DWR Erosion Survey	0.12	0.17	0.80	0.42%					
DWR UCIP Field Study					1.29	0.05			
DWR UCIP LMA Responsibility									
<i>LMA Totals:</i>	55.33	12.79	106.49	55.67%	10.59	0.65	0.00	0.00

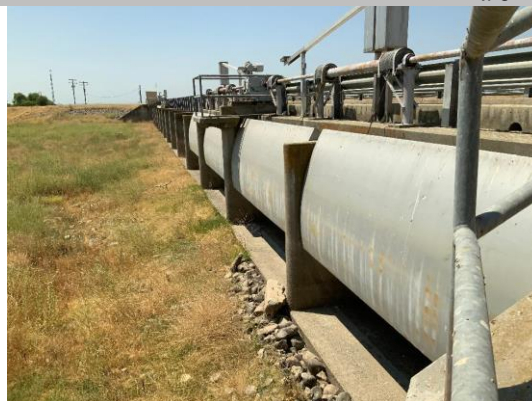
Photo 2 of 3 : UCIP\_FA\_2021\_69963\_102283.jpg

DS\_ID:19739  
 FS\_ID:69963  
 EP\_NO: N/A  
 Repair Type: Non-Urgent  
 EVAL Issue: Unauthorized Encroachment, installed decades prior  
 Crossing Status: Found  
 UCIP Comments: 07/13/2021 The record remains Non-Urgent. No permit was found authorizing this encroachment. CVFPB will need to review crossing to determine owner. Crossing appears in good condition. The UCIP inspection was completed with GEI staff, P. Espinoza. (H. Dunn – GEI) 10/27/2017 This structure is inspected annually under the Structure and Channel Summer Inspection (part of the Levee Inspection Program) conducted by the DWR Flood Project Integrity and Inspection Branch (FPIIB). (O. Magana - DWR UCIP) 04/21/2014 Accidentally missed--need photos. (O. Magana - DWR UCIP)  
 FIELD\_STRUCT\_DESC: [Mariposa Bypass Structure] 2 of 6:  
 Approximately 14 reinforced concrete box gravity drainage culverts of an unknown size across the intersection of the Mariposa Bypass and the Eastside Bypass. Roadway across structure. Controlled slide gates on end four culverts, both sides. Wing wall on each side of the structure. Rock revetment immediately downstream of the structure.

LS view: Slidegates along bridge at toe.

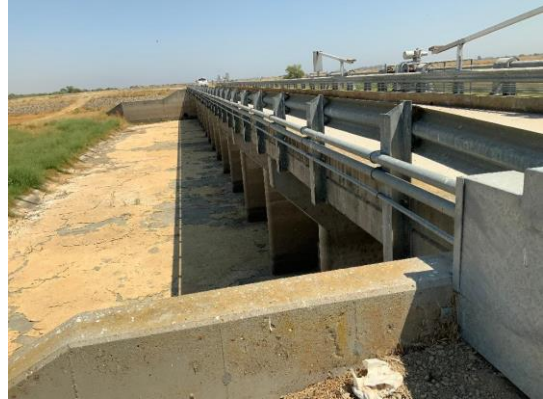
Photo 2 of 3 : UCIP\_FA\_2021\_68489\_102297.jpg

DS\_ID:19741  
 FS\_ID:68489  
 EP\_NO: N/A  
 Repair Type: Non-Urgent  
 EVAL Issue: Unauthorized Encroachment, installed decades prior  
 Crossing Status: Found  
 UCIP Comments: 07/13/2021 The record remains Non-Urgent. No permit was found authorizing this encroachment. CVFPB will need to review crossing to determine owner. Crossing appears in good condition. The UCIP inspection was completed with GEI staff, P. Espinoza. (H. Dunn – GEI) 10/27/2017 This structure is inspected annually under the Structure and Channel Summer Inspection (part of the Levee Inspection Program) conducted by the DWR Flood Project Integrity and Inspection Branch (FPIIB). (DWR UCIP - O. Magana) 04/21/2014 Accidentally missed--need photos (DWR UCIP - O. Magana) FIELD\_STRUCT\_DESC: [Mariposa Bypass Structure] 4 of 6: Approximately 14 reinforced concrete box gravity drainage culverts of an unknown size across the intersection of the Mariposa Bypass and the Eastside Bypass. Roadway across structure. Controlled slide gates on end four culverts, both sides. Wing wall on each side of the structure. Rock revetment immediately downstream of the structure. [Additional Reference(s): DWR Levee Log, 2002. USACE San Joaquin O&M Manual 601.2, 1969].

LS view: Inlet culverts along bridge at toe.

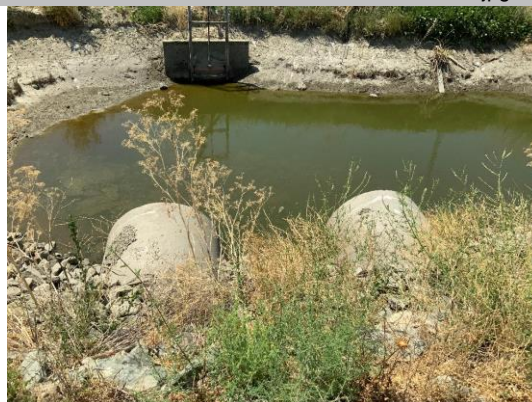
Photo 2 of 3 : UCIP\_FA\_2021\_69965\_102313.jpg

DS\_ID:25541  
FS\_ID:69965  
EP\_NO: 18961  
Repair Type: Non-Urgent  
EVAL Issue: Limited Inspection/No UCIP Evaluation  
Crossing Status: Found  
UCIP Comments: 07/13/2021 The record is Non-Urgent. Crossing is new since the last inspection and has replaced the pipe for DSID 19874. Limited inspection of LS pipe inlet due to standing water and barbed wire. The UCIP inspection was completed with GEI staff, P. Espinoza. (H. Dunn – GEI) 09/23/2020 UCIP record brought online. (O. Magana - DWR UCIP)  
FIELD\_STRUCT\_DESC: [East Side Bypass Siphon] 2 of 2. 54-inch rubber gasket reinforced concrete pipe (RGRCP) through the levee, at an unknown depth below the levee crown. Line goes through Unit 5 levee and under the East Side Bypass Channel and goes through Unit 6 levee. Inlet structure and pump station are located on the north side of Unit 5. Concrete standpipes (siphons) located in the channel. Screw gates located on the north side of Unit 6. Electrical box located on the levee crown of Unit 6. (two 54-inch siphon lines installed under Permit 18961, 2016 - Henry Miller Reclamation District, existing 48-inch line was removed)

LS view: Closeup of pipe inlets at toe under water.

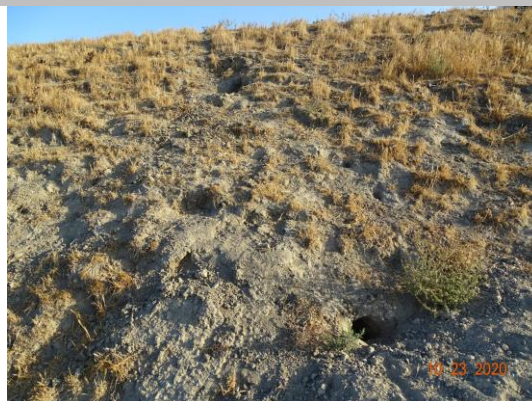
Photo 1 of 1 : FA\_2021\_NA0010\_124\_103\_20210830\_00031.jpg

LM Start	9.67	Rating **	M	Issue No.	103
LM End	9.71	Issue Type +	Ma	Location *	LS
Category	Earthen Levee			GPS Latitude/Longitude	
				Start	End
Item	Animal Control			37.200934 °	37.200836 °
				-120.694084 °	-120.693406 °
DWR ID	DWR_NA0010_06_f_2020_103				
Comment Code					
A3 : No rodents visible, but rodent burrows visible; need to backfill and compact or grout burrows.					
Inspector Comment

Rodent holes in the landside slope. (Fall 2020)

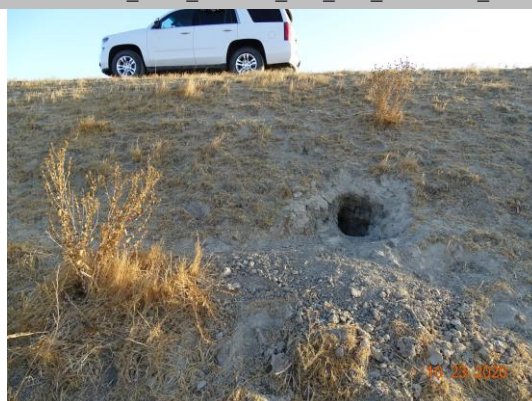
Photo 1 of 1 : FA\_2021\_NA0010\_124\_102\_20210830\_00030.jpg

LM Start	10.12	Rating **	U	Issue No.	102
LM End	10.12	Issue Type +	Ma	Location *	LS
Category	Earthen Levee			GPS Latitude/Longitude	
				Start	End
Item	Animal Control			37.196845 °	37.196845 °
				-120.687892 °	-120.687892 °
DWR ID	DWR_NA0010_06_f_2020_102				
Comment Code					
A3 : No rodents visible, but rodent burrows visible; need to backfill and compact or grout burrows.					
Inspector Comment

View of large animal burrow in the landside slope. (Fall 2020)

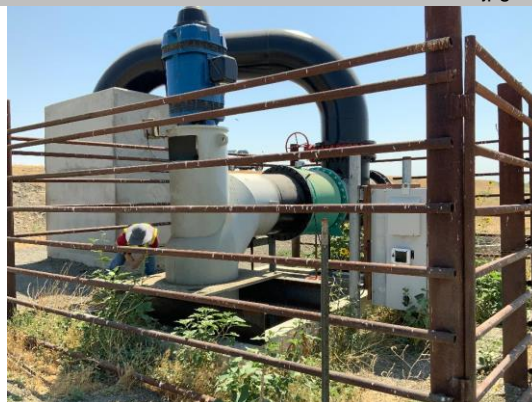
Photo 2 of 3 : UCIP\_FA\_2021\_69966\_102319.jpg

Comment Code						
Inspector Comment						
DS_ID:19563 FS_ID:69966 EP_NO: 18624 Repair Type: Non-Urgent EVAL Issue: Limited Inspection/No UCIP Evaluation Crossing Status: Found UCIP Comments: 07/13/2021 The record has been upgraded from No Action Needed to Non-Urgent. WS outlets were underwater at time of inspection, limited inspection. There appears to be a new pump and pipe system off the LS toe. Confirm with owner on the status of this crossing. The UCIP inspection was completed with GEI staff, P. Espinoza. (H. Dunn – GEI) FIELD_STRUCT_DESC: 36-inch reinforced concrete water supply pipe through the levee, 5 feet below the crown. Pipe riser on both the inlet and the outlet sides. Control gate on the landside (LS). Slide gate on the waterside (WS) end. Joints secured in hoop steel and encased in concrete at each levee toe. (36-inch water pipe through levee, under and across channel, authorized Permit No. 18624, 2010, Wolfsen Land and Cattle Company). FS Date: 7/13/2021

LS view: New pump and pipe system off the toe.

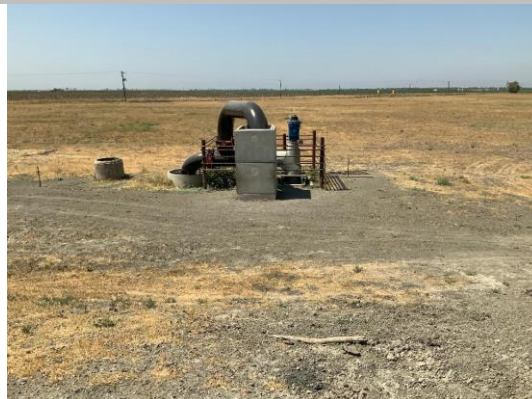
Photo 3 of 3 : UCIP\_FA\_2021\_69966\_102316.jpg

LS view: New pumps and pipe system off toe.

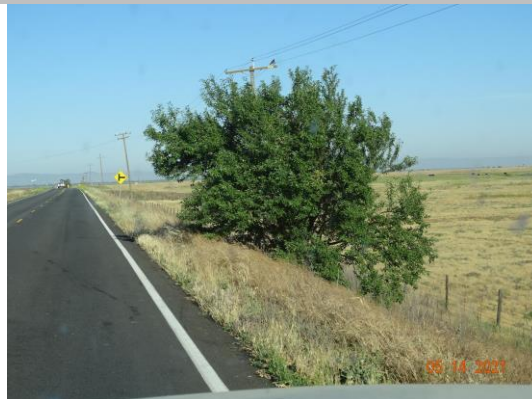
Photo 1 of 1 : FA\_2021\_NA0010\_124\_14\_20210830\_00003.jpg

LM Start	11.49	Rating **	M	Issue No.	14
LM End	11.49	Issue Type +	Ma	Location *	WS
Category	Earthen Levee			GPS Latitude/Longitude	
				Start	End
Item	Trim / Thin Trees			37.186189 °	37.186189 °
				-120.668476 °	-120.668476 °
DWR ID	DWR_NA0010_06_s_2015_14				
Comment Code					
T1 : Trim trees to at least five feet above ground level.					
Inspector Comment					
Almond tree located along Sandy Mush Road on waterside slope.

Looking west at tree on waterward slope. (Spring 2021)

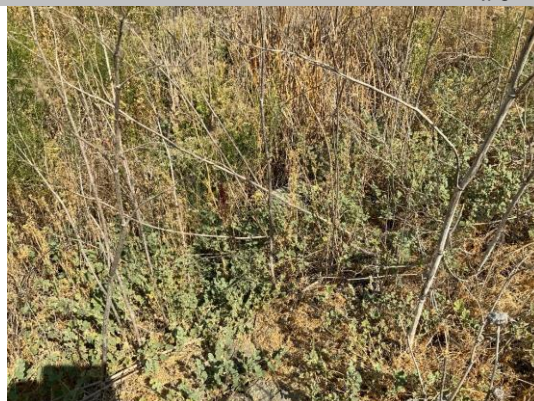
Photo 2 of 3 : UCIP\_FA\_2021\_69968\_102328.jpg

DS\_ID:19876  
 FS\_ID:69968  
 EP\_NO: N/A  
 Repair Type: Non-Urgent  
 EVAL Issue: Limited Inspection/No UCIP Evaluation  
 Crossing Status: Found  
 UCIP Comments: 07/13/2021 The record remains Non-Urgent. Dense vegetation over LS inlet and WS outlet, recommend removal of vegetation from both sides. Limited inspection of both inlet and outlet. No permit was found authorizing this encroachment. CVFPB will need to review crossing to determine owner. The UCIP inspection was completed with GEI staff, P. Espinoza. (H. Dunn – GEI) 04/17/2014 Clear debris from waterward and landward toes. (O. Magana - DWR UCIP)  
 FIELD\_STRUCT\_DESC: 36-inch corrugated metal gravity drainage pipe through the levee, 17 feet below the crown. Slide gate in a pipe riser on the waterside (WS) slope. [Additional Reference(s): DWR Levee Log, 2002 (HLM 11.83), listed as a 36-inch corrugated metal pipe (CMP). USACE San Joaquin O&M Manual, Unit 601 Part 1 (SJR601.1), 1967, Revised 25 May 2011, (HLM 11.82), listed as a 36-inch CMP].

WS view: Flapgate barely visible under dense vegetation at toe.

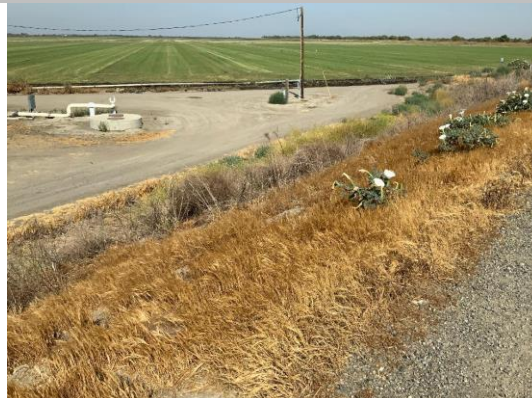
Photo 2 of 3 : UCIP\_FA\_2021\_69977\_102396.jpg

DS\_ID:19878  
FS\_ID:69977  
EP\_NO: N/A  
Repair Type: Non-Urgent  
EVAL Issue: Limited Inspection/No UCIP Evaluation  
Crossing Status: Found  
UCIP Comments: 07/13/2021 The record remains Non-Urgent. Limited inspection due to LS pipe inlet not being found, assuming its completely buried. Recommend removing dirt and vegetation to find alignment and confirming with owner on the status of this pipe. No permit was found authorizing this encroachment. CVFPB will need to review crossing to determine owner. The UCIP inspection was completed with GEI staff, P. Espinoza. (H. Dunn – GEI) 04/17/2014 Not accessible--crossing is buried on landward side. Need to contact owner to determine status. (O. Magana - DWR UCIP)  
FIELD\_STRUCT\_DESC: 24-inch corrugated metal gravity drainage pipe through the levee, 12.3 feet below the crown. Flap gate on the waterside (WS) end. [Additional Reference(s): DWR Levee Log, 2002 (HLM 14.45), listed as a 24-inch corrugated metal pipe (CMP). USACE San Joaquin O&M Manual, Unit 601 Part 1 (SJR601.1), 1967, Revised 25 May 2011, (HLM 14.44), listed as a 24-inch CMP]

LS view: Slope from crown, no pipe visible.

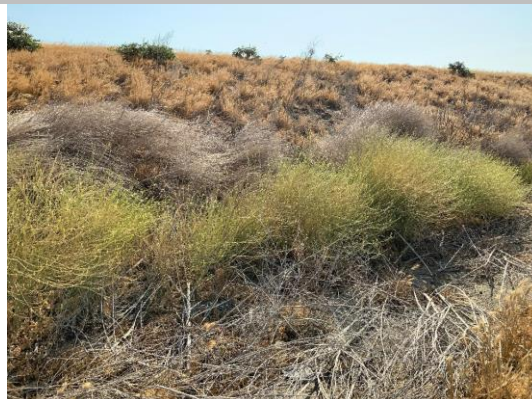
Photo 3 of 3 : UCIP\_FA\_2021\_69977\_102397.jpg

LS view: Slope from toe, no pipe visible.

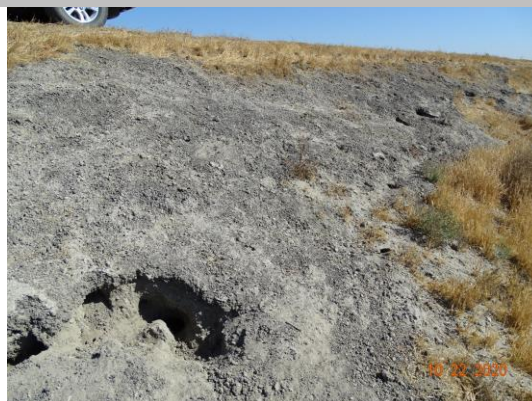
Photo 1 of 1 : FA\_2021\_NA0010\_124\_98\_20210830\_00027.jpg

LM Start	14.37	Rating **	U	Issue No.	98
LM End	14.37	Issue Type +	Ma	Location *	WS
Category	Earthen Levee			GPS Latitude/Longitude	
				Start	End
Item	Animal Control			37.167740 °	37.167740 °
				-120.636282 °	-120.636282 °
DWR ID	DWR_NA0010_06_f_2020_98				
Comment Code					
A3 : No rodents visible, but rodent burrows visible; need to backfill and compact or grout burrows.					
Inspector Comment

Looking upstream along the waterside slope. (Fall 2020)

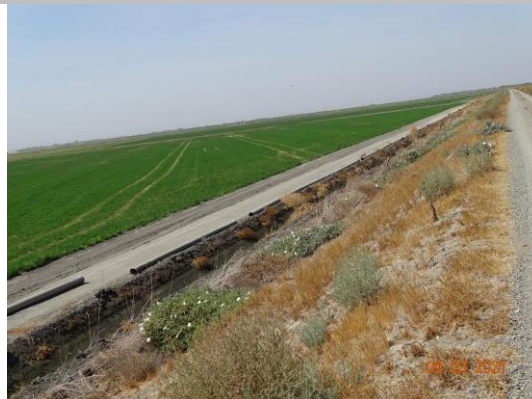
Photo 1 of 1 : FA\_2021\_NA0010\_124\_119\_20210929\_00219.jpg

LM Start	14.71	Rating **	M	Issue No.	119
LM End	15.23	Issue Type +	En	Location *	LS
Category	Earthen Levee			GPS Latitude/Longitude	
				Start	End
Item	Encroachments			37.164000 °	37.160390 °
				-120.632225 °	-120.623995 °
DWR ID	DWR_NA0010_06_f _ 2021_119				
Comment Code					
DT : Ditch					
Inspector Comment					
Ditch dug approximate 10 - 15 feet from the landside toe.

Ditch landowner has dug on the landside toe. (Fall 2021)

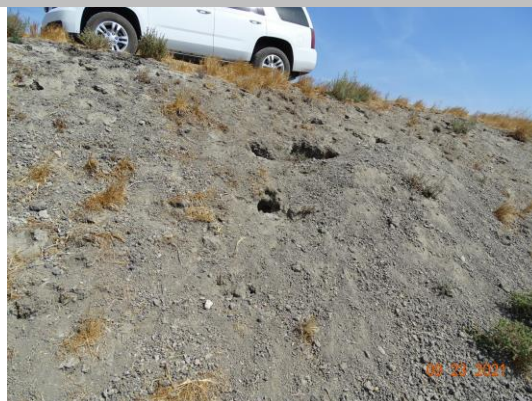
Photo 1 of 1 : FA\_2021\_NA0010\_124\_124\_20210929\_00220.jpg

LM Start	15.31	Rating **	U	Issue No.	124
LM End	15.70	Issue Type +	Ma	Location *	LS
Category	Earthen Levee			GPS Latitude/Longitude	
				Start	End
Item	Animal Control			37.159932 °	37.157217 °
				-120.622810 °	-120.618915 °
DWR ID	DWR_NA0010_06_s_2012_124				
Comment Code					
A1 : Exterminate rodents and backfill and compact or grout burrows.					
Inspector Comment

Large rodent burrows observed in the landside slope. (Fall 2021)

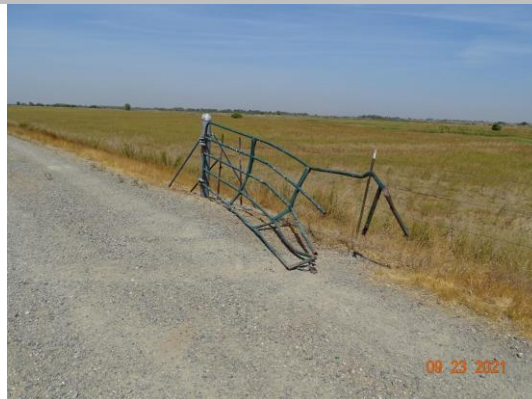
Photo 1 of 1 : FA\_2021\_NA0010\_124\_118\_20210929\_00221.jpg

LM Start	15.66	Rating **	U	Issue No.	118
LM End	15.66	Issue Type +	Ma	Location *	CR
Category	Earthen Levee			GPS Latitude/Longitude	
				Start	End
Item	Repair Gates			37.157109 °	37.157109 °
				-120.617443 °	-120.617443 °
DWR ID	DWR_NA0010_06_f_2021_118				
Comment Code					
Inspector Comment					
The gate at W Chamberlain Rd crossing has been destroyed. It should be replaced or removed.

View of destroyed gate. (Fall 2021)

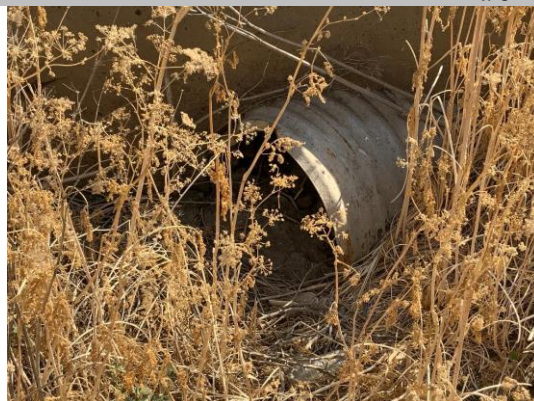
Photo 2 of 3 : UCIP\_FA\_2021\_69810\_102351.jpg

Comment Code						
Inspector Comment						
DS_ID:19884 FS_ID:69810 EP_NO: N/A Repair Type: Non-Urgent EVAL Issue: Limited Inspection/No UCIP Evaluation Crossing Status: Found UCIP Comments: 07/13/2021 The record remains Non-Urgent. Limited inspection of LS pipe inlet. LS pipe edges are warped and inlet filled with sediment and some vegetation, recommend cleaning out. No permit was found authorizing this encroachment. CVFPB will need to review crossing to determine owner. The UCIP inspection was completed with GEI staff, P. Espinoza. (H. Dunn – GEI) 04/17/2014 Need to contact owner. Sediment buildup on both the waterward and landward side. Recommend removing sediment buildup from both side. Also recommend clearing excess sediment inside crossing. (O. Magana - DWR UCIP) FIELD_STRUCT_DESC: 24-inch corrugated metal gravity drainage pipe through the levee, 14 feet below the crown. Flap gate on the waterside (WS) end. [Additional Reference(s): DWR Levee Log, 2002 (HLM 15.78), listed as a 24-inch corrugated metal pipe (CMP). USACE San Joaquin O&M Manual, Unit 601 Part 1 (SJR601.1), 1967, Revised 25 May 2011, (HLM 15.76), listed as a 24-inch CMP]. FS Date: 7/13/2021

LS view: Closeup of pipe inlet at toe with sediment buildup.

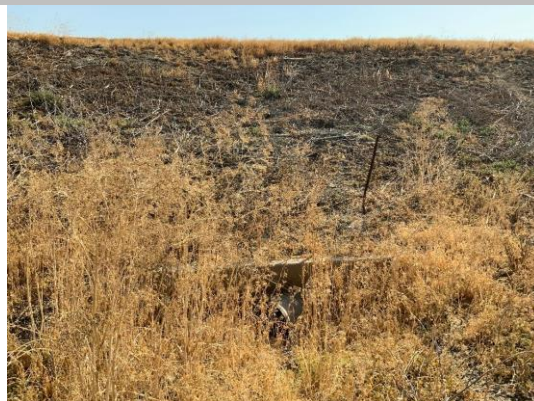
Photo 3 of 3 : UCIP\_FA\_2021\_69810\_102350.jpg

LS view: Headwall visible at toe.

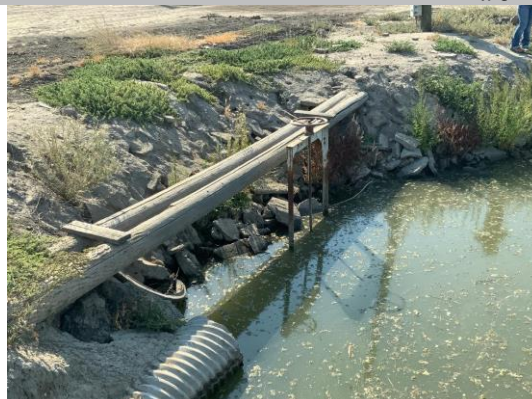
Photo 2 of 3 : UCIP\_FA\_2021\_69978\_102365.jpg

Comment Code						
Inspector Comment						
DS_ID:19885 FS_ID:69978 EP_NO: N/A Repair Type: Non-Urgent EVAL Issue: Limited Inspection/No UCIP Evaluation Crossing Status: Found UCIP Comments: 07/13/2021 The record remains Non-Urgent. LS pipe inlet was underwater at time of inspection. WS flapgate was buried under sediment, limited inspection on both ends. Recommend removal of sediment covering flapgate on WS. No permit was found authorizing this encroachment. CVFPB will need to review crossing to determine owner. The UCIP inspection was completed with GEI staff, P. Espinoza. (H. Dunn – GEI) 04/17/2014 Need to contact owner to determine status of crossing. Waterward side is buried and not accessible. Landward side headwall is blocked by dense vegetation. Recommend confirming status of flap gate on waterward side and removing dense vegetation form landward side. (O. Magana - DWR UCIP) FIELD_STRUCT_DESC: 36-inch corrugated metal gravity drainage pipe through the levee, 16.6 feet below the crown. Flap gate on the waterside (WS) end. [Additional Reference(s): DWR Levee Log, 2002 (HLM 15.93), listed as a 36-inch corrugated metal pipe (CMP). USACE San Joaquin O&M Manual, Unit 601 Part 1 (SJR601.1), 1967, Revised 25 May 2011, (HLM 15.91), listed as a 36-inch CMP] FS Date: 7/13/2021

LS view: Closeup of slidegate underwater at toe.

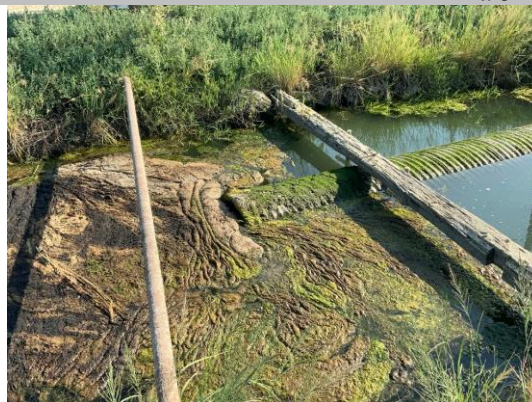
Photo 2 of 3 : UCIP\_FA\_2021\_69812\_102367.jpg

DS\_ID:19559  
FS\_ID:69812  
EP\_NO: N/A  
Repair Type: Non-Urgent  
EVAL Issue: Limited Inspection/No UCIP Evaluation  
Crossing Status: Found  
UCIP Comments: 07/13/2021 The record remains Non-Urgent. Both WS inlet and LS outlet were underwater at the time of inspection, limited inspection. No permit was found authorizing this encroachment. CVFPB will need to review crossing to determine owner. The UCIP inspection was completed with GEI staff, P. Espinoza. (H. Dunn – GEI)

LS view: Close up of pipe outlet underwater off toe.

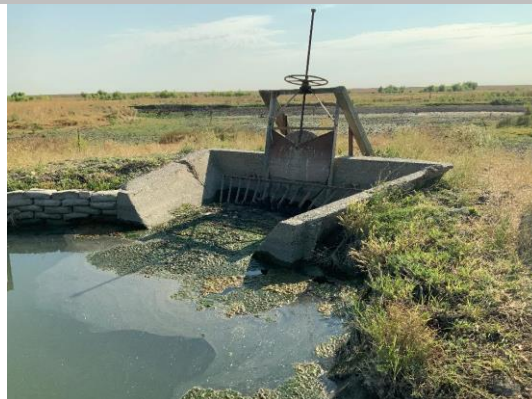
Photo 2 of 3 : UCIP\_FA\_2021\_69979\_102378.jpg

DS\_ID:19886  
 FS\_ID:69979  
 EP\_NO: 3040  
 Repair Type: Non-Urgent  
 EVAL Issue: Limited Inspection/No UCIP Evaluation  
 Crossing Status: Indicator Found  
 UCIP Comments: 07/13/2021 The record is Non-Urgent. WS slidegate is visible off the toe at the end of a small channel with the right diameter size, but does not go through the levee. Confirm with owner on the status of this crossing, alignment, and if this slidegate is the correct indicator. Limited inspection due to water being present around the inlet at time of survey. The UCIP inspection was completed with GEI staff, P. Espinoza. (H. Dunn – GEI)  
 FIELD\_STRUCT\_DESC: 48-inch corrugated metal irrigation siphon pipe through the levee, 8.7 feet below the crown. Slide gate on the landside (LS). Cobble revetment around each end of the pipe. Siphon extends under the channel. 24-inch corrugated metal cleanout pipe at the center of the channel with a metal plate cover. (Plans for construction of two reinforced concrete siphons across the Eastside Bypass authorized under Permit No. 3040, 1959 - Newhall Land and Farming Company). [Additional Reference(s): DWR Levee Log, 2002 (HLM 16.52), listed as a 48-inch corrugated metal pipe (CMP)].

WS view: Headwall and slidegate off the toe within small channel.

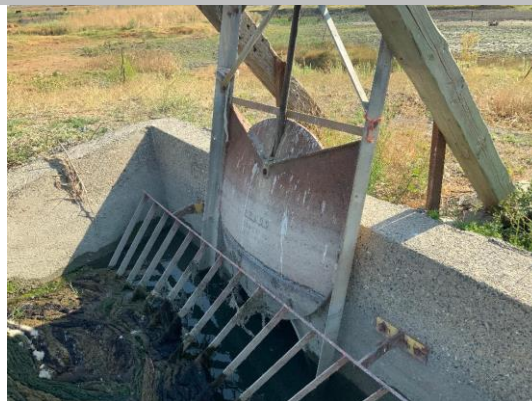
Photo 3 of 3 : UCIP\_FA\_2021\_69979\_102379.jpg

WS view: Closeup of slidegate off toe.

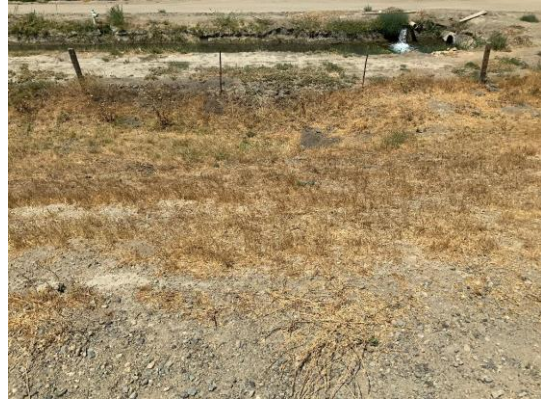
Photo 2 of 3 : UCIP\_FA\_2021\_69813\_101419.jpg

Comment Code						
Inspector Comment						
DS_ID:19887 FS_ID:69813 EP_NO: N/A Repair Type: Non-Urgent EVAL Issue: Limited Inspection/No UCIP Evaluation Crossing Status: Found UCIP Comments: 07/12/2021 The record remains Non-Urgent. LS pipe inlet filled with sediment, recommend removal. WS flapgate has some vegetation over it, recommend removal. Limited inspection on both WS and LS. No permit was found authorizing this encroachment. CVFPB will need to review crossing to determine owner. The UCIP inspection was completed with GEI staff, P. Espinoza. (H. Dunn – GEI)						
04/17/2014 Sediment build up on landward side toe -- debris blockage. No photos available. Recommend taking photos of crossing. (O. Magana - DWR UCIP) FIELD_STRUCT_DESC: 24-inch corrugated metal gravity drainage pipe through the levee, 11.5 feet below the crown. Flap gate on the waterside (WS) end. [Additional Reference(s): DWR Levee Log, 2002 (HLM 18.29), listed as a 24-inch corrugated metal pipe (CMP). USACE San Joaquin O&M Manual, Unit 601 Part 1 (SJR601.1), 1967, Revised 25 May 2011, (HLM 18.27), listed as a 24-inch CMP]. FS Date: 7/13/2021

LS view: Toe from crown.

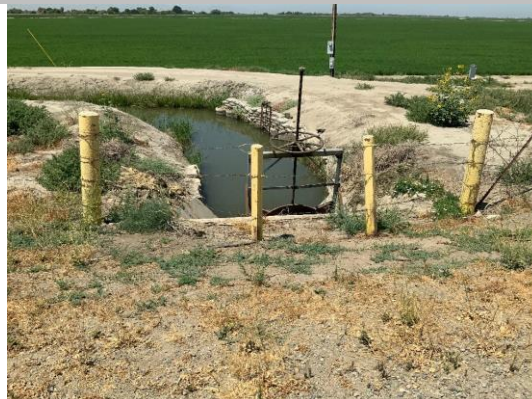
Photo 2 of 3 : UCIP\_FA\_2021\_67964\_101448.jpg

DS\_ID:19888  
FS\_ID:67964  
EP\_NO: 3040  
Repair Type: Non-Urgent  
EVAL Issue: Limited Inspection/No UCIP Evaluation  
Crossing Status: Found  
UCIP Comments: 07/12/2021 The record has been downgraded from Urgent to Non-Urgent. LS gate open and water flowing through during inspection. Did not observe leaks as stated in previous inspection. WS pipe end goes under channel so unable to inspect. The UCIP inspection was completed with GEI staff, P. Espinoza. (H. Dunn – GEI)

LS view: Slidegate visible at toe from crown.

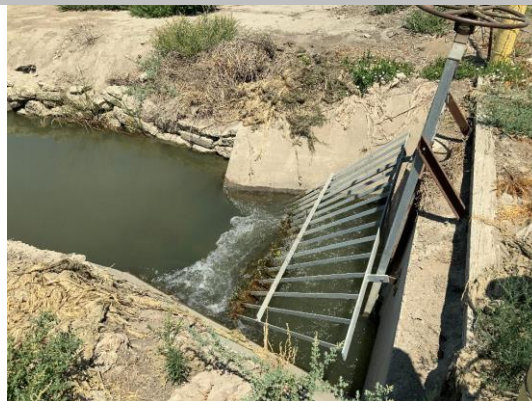
Photo 3 of 3 : UCIP\_FA\_2021\_67964\_101449.jpg

LS view: Closeup of slidegate at toe.

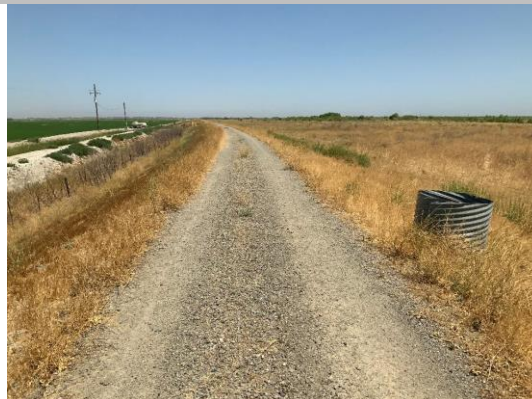
Waterway	Bank	Unit Miles	Inspection Start/End	Inspector
Unit No. 01 San Joaquin River	Right	22.52	09/14/2021 09/14/2021	Corey Fujitani

DS\_ID:19889  
FS\_ID:69980  
EP\_NO: N/A  
Repair Type: Non-Urgent  
EVAL Issue: Safety Issue  
Crossing Status: Found  
UCIP Comments: 07/12/2021 The record remains Non-Urgent. Barbed wire over LS end, could not inspect closely. No cover over WS riser, causing safety hazard. Slightly warped edges on both WS and LS pipe inlet/outlet. No permit was found authorizing this encroachment. CVFPB will need to review crossing to determine owner. The UCIP inspection was completed with GEI staff, P. Espinoza. (H. Dunn – GEI)

Levee crown.

04/17/2014 Dense vegetation limits the inspector's visibility to identify signs of pipe failure (leaks) along the landward slope. Recommend removing vegetation along pipe alignment to conduct proper inspection of structure. (O. Magana - DWR UCIP)

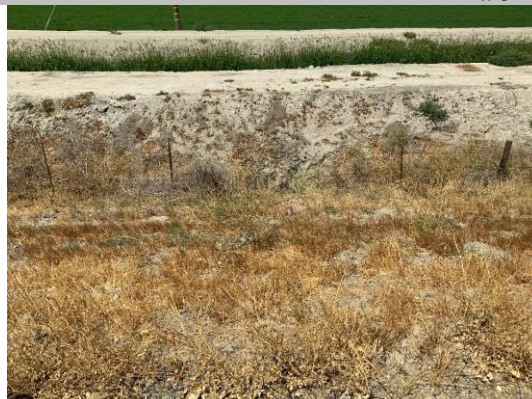
Photo 2 of 3 : UCIP\_FA\_2021\_69980\_101559.jpg

LS view: Toe from crown.

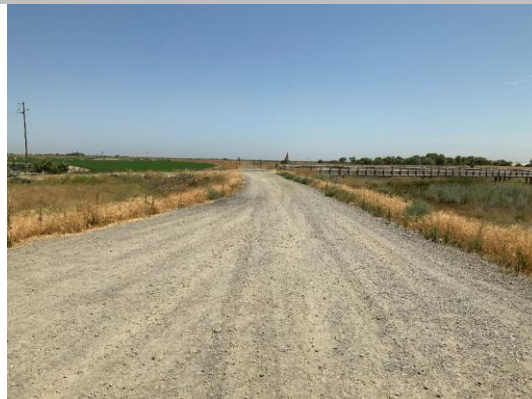
Photo 1 of 3 : UCIP\_FA\_2021\_68011\_101574.jpg

Comment Code						
Inspector Comment						
DS_ID:19890 FS_ID:68011 EP_NO: N/A Repair Type: Non-Urgent EVAL Issue: Limited Inspection/No UCIP Evaluation Crossing Status: Found UCIP Comments: 07/12/2021 The record remains Non-Urgent. WS pipe outlet visible but underwater, unable to inspect closely. LS pipe inlet was not seen, but likely underwater. No permit was found authorizing this encroachment. CVFPB will need to review crossing to determine owner. The UCIP inspection was completed with GEI staff, P. Espinoza. (H. Dunn – GEI) 04/17/2014 Dense vegetation limits the inspector's visibility to identify signs of pipe failure (leaks) along the slopes. Recommend removing vegetation along pipe alignment to conduct proper inspection of structure. (O. Magana - DWR UCIP) FIELD_STRUCT_DESC: 48-inch corrugated metal gravity drainage pipe through the levee, 20 feet below the crown. Slide gate in a pipe riser on the waterside (WS) slope. Riprap along the landside (LS) slope. [Additional Reference(s): DWR Levee Log, 2002 (HLM 19.36), listed as a 48-inch corrugated metal pipe (CMP). USACE San Joaquin O&M Manual, Unit 601 Part 1 (SJR601.1), 1967, Revised 25 May 2011, (HLM 19.36), listed as a 48-inch CMP]. FS Date: 7/12/2021

Levee crown.

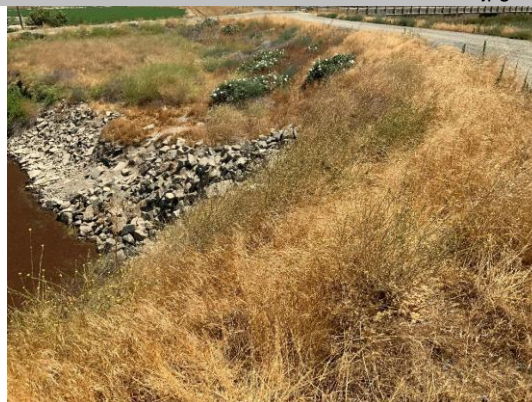
Photo 2 of 3 : UCIP\_FA\_2021\_68011\_101575.jpg

LS view: Slope from crown, no pipe visible.

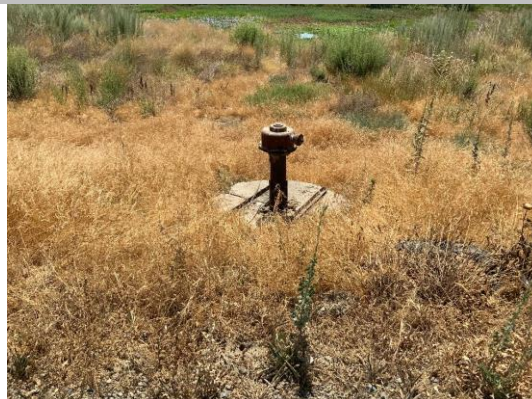
Photo 3 of 3 : UCIP\_FA\_2021\_68011\_101576.jpg

WS view: Slidegate visible on slope from crown.

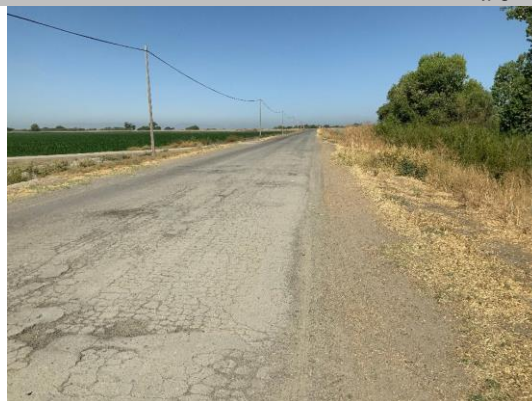
Photo 1 of 3 : UCIP\_FA\_2021\_69814\_101582.jpg

DS\_ID:19891  
FS\_ID:69814  
EP\_NO: N/A  
Repair Type: Non-Urgent  
EVAL Issue: Limited Inspection/No UCIP Evaluation  
Crossing Status: Found  
UCIP Comments: 07/12/2021 The record remains Non-Urgent. Limited inspection due to dense vegetation on LS and WS ends, LS headwall just barely visible, recommend removal of vegetation. No permit was found authorizing this encroachment. CVFPB will need to review crossing to determine owner. The UCIP inspection was completed with GEI staff, P. Espinoza. (H. Dunn – GEI) 04/17/2014 Dense vegetation limits the inspector's visibility to identify signs of pipe failure (leaks) along the slopes. Recommend removing vegetation along pipe alignment to conduct proper inspection of structure. (O. Magana - DWR UCIP)  
FIELD\_STRUCT\_DESC: 30-inch by 30-inch reinforced concrete box gravity drainage culvert through the levee, 14 feet below the crown. Flap gate on the waterside (WS) end. [Additional Reference(s): DWR Levee Log, 2002 (HLM 19.82), listed as a 2.5-foot by 2.5-foot reinforced concrete box culvert (RCBC). USACE San Joaquin O&M Manual, Unit 601 Part 1 (SJR601.1), 1967, Revised 25 May 2011, (HLM 19.85), listed as a 2.5-foot by 2.5 foot RCBC].

Levee crown.

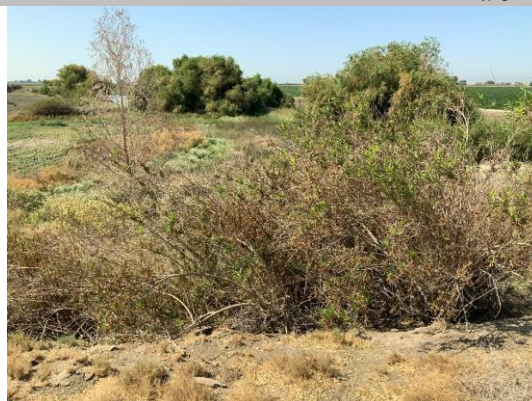
Photo 2 of 3 : UCIP\_FA\_2021\_69814\_101578.jpg

LS view: Toe from crown.

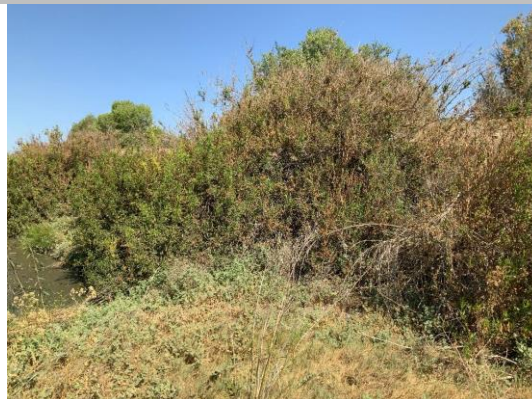
Photo 3 of 3 : UCIP\_FA\_2021\_69814\_101579.jpg

LS view: Dense vegetation over pipe inlet at toe, pipe not visible.

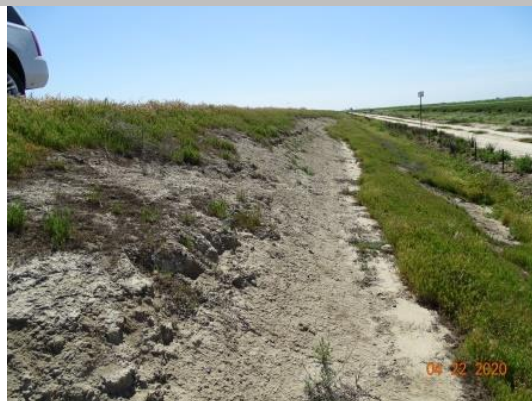
Photo 1 of 1 : FA\_2021\_NA0010\_124\_1209\_20210830\_00040.jpg

LM Start	20.79	Rating **	M	Issue No.	1209
LM End	21.19	Issue Type +	Ma	Location *	LS
Category	Earthen Levee			GPS Latitude/Longitude	
				Start	End
Item	Animal Control			37.113107 °	37.108653 °
				-120.563782 °	-120.558977 °
DWR ID	DWR_NA0010_06_s_2015_1209				
Comment Code					
A2 : Repair the levee slope damaged by livestock and prevent large animal access.					
Inspector Comment					
Erosion on landside slope greater than 3 inches. Erosion caused by livestock.

Erosion on the landside slope from livestock activity. (Spring 2020)

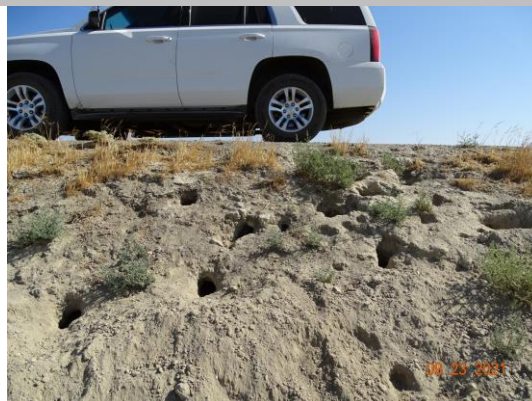
Photo 1 of 1 : FA\_2021\_NA0010\_124\_113\_20210929\_00222.jpg

LM Start	21.30	Rating **	U	Issue No.	113
LM End	21.30	Issue Type +	Ma	Location *	LS
Category	Earthen Levee			GPS Latitude/Longitude	
				Start	End
Item	Animal Control			37.107502 °	37.107502 °
				-120.557813 °	-120.557813 °
DWR ID	DWR_NA0010_06_f_2021_113				
Comment Code					
A3 : No rodents visible, but rodent burrows visible; need to backfill and compact or grout burrows.					
Inspector Comment

Several rodent holes observed at this location. (Fall 2021)

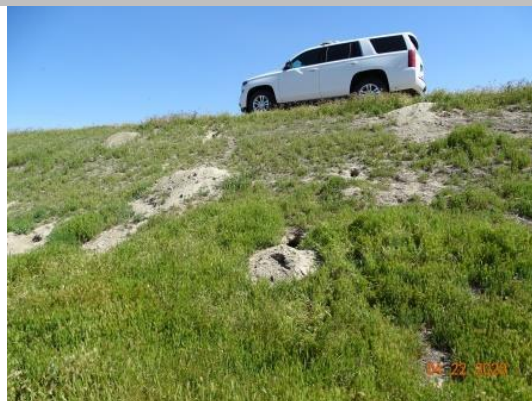
Photo 1 of 1 : FA\_2021\_NA0010\_124\_114\_20210830\_00034.jpg

LM Start	21.39	Rating **	M	Issue No.	114
LM End	21.39	Issue Type +	Ma	Location *	LS
Category	Earthen Levee			GPS Latitude/Longitude	
				Start	End
Item	Animal Control			37.106397 °	37.106397 °
				-120.556727 °	-120.556727 °
DWR ID	DWR_NA0010_06_f_2019_114				
Comment Code					
A3 : No rodents visible, but rodent burrows visible; need to backfill and compact or grout burrows.					
Inspector Comment

View of rodent burrows on the landside slope. (Spring 2020)

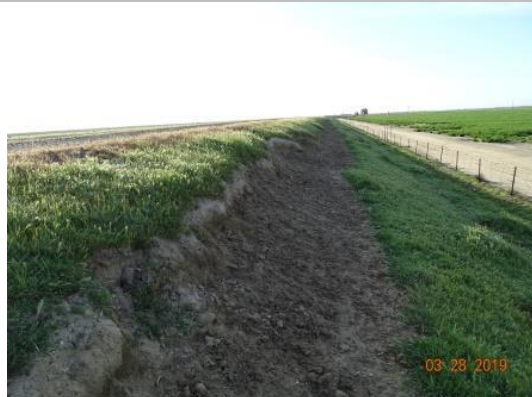
Photo 1 of 1 : FA\_2021\_NA0010\_124\_107\_20210830\_00033.jpg

LM Start	21.71	Rating **	M	Issue No.	107
LM End	21.78	Issue Type +	Ma	Location *	LS
Category	Earthen Levee			GPS Latitude/Longitude	
				Start	End
Item	Animal Control			37.102844 °	37.102002 °
				-120.553160 °	-120.552314 °
DWR ID	DWR_NA0010_06_f _ 2018_107				
Comment Code					
A2 : Repair the levee slope damaged by livestock and prevent large animal access.					
Inspector Comment					
Erosion into levee prism due to livestock activities.

View of erosion in landside levee prism. (Spring 2019)

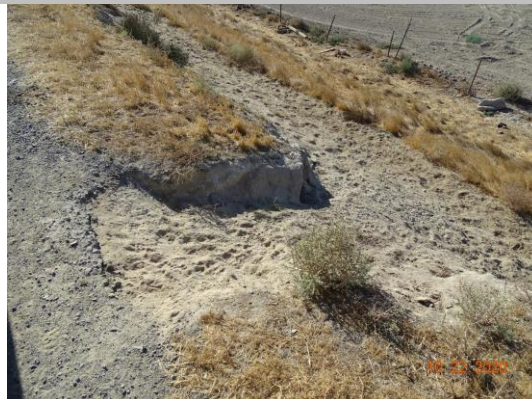
Photo 1 of 1 : FA\_2021\_NA0010\_124\_91\_20210830\_00024.jpg

LM Start	21.82	Rating **	M	Issue No.	91
LM End	22.06	Issue Type +	Ma	Location *	LS
Category	Earthen Levee			GPS Latitude/Longitude	
				Start	End
Item	Animal Control			37.101617 °	37.098894 °
				-120.551909 °	-120.549178 °
DWR ID	DWR_NA0010_06_f _ 2020_91				
Comment Code					
A2 : Repair the levee slope damaged by livestock and prevent large animal access.					
Inspector Comment

Cattle trail damage to the landside slope and shoulder. (Fall 2020)

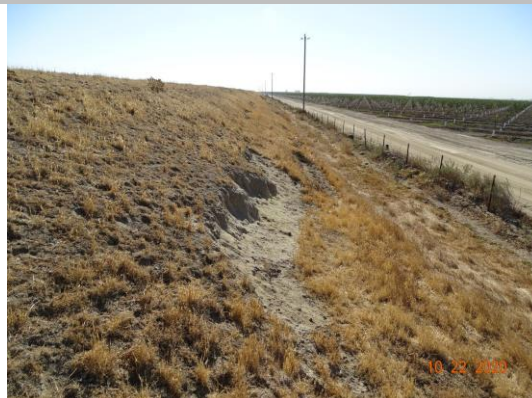
Photo 1 of 1 : FA\_2021\_NA0010\_124\_86\_20210830\_00021.jpg

LM Start	22.09	Rating **	M	Issue No.	86
LM End	22.46	Issue Type +	Ma	Location *	LS
Category	Earthen Levee			GPS Latitude/Longitude	
				Start	End
Item	Animal Control			37.098524 °	37.094479 °
				-120.548781 °	-120.544435 °
DWR ID	DWR_NA0010_06_f _ 2017_86				
Comment Code					
A2 : Repair the levee slope damaged by livestock and prevent large animal access.					
Inspector Comment					
Erosion greater than 3 inches on landside slope caused by livestock.

Looking upstream along the landside slope. (Fall 2020)

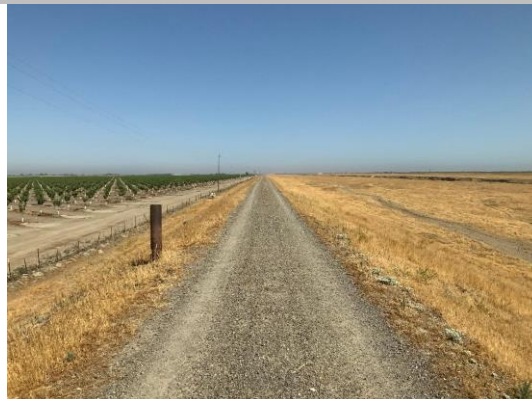
Photo 1 of 3 : UCIP\_FA\_2021\_70005\_101599.jpg

Comment Code						
Inspector Comment						
DS_ID:19812 FS_ID:70005 EP_NO: 12657 Repair Type: Non-Urgent EVAL Issue: Limited Inspection/No UCIP Evaluation Crossing Status: Found UCIP Comments: 07/12/2021 The record has been upgraded from No Action Needed to Non-Urgent. One of the attached pipes on WS appears to have been removed and is not attached. Unable to access LS riser due to barbed wire. The UCIP inspection was completed with GEI staff, P. Espinoza. (H. Dunn – GEI) FIELD_STRUCT_DESC: 16-inch coated steel irrigation discharge pipe through the levee, 4 feet below the crown. Portable pump on the waterside (WS). Concrete standpipe on landside (LS) slope with a timber walkway access. Siphon breaker on the LS shoulder. Cutoff wall around the pipe at the center of the levee. Intake trench from the channel to the WS toe. (Plans to install a diversion pump in the Eastside Bypass with a discharge pipeline through the levee authorized under Permit No. 12657, 1979 - Laurie H. Hall, Mary H. Hicks, and William E. Hammonds). [Additional Reference(s): DWR Levee Log, 2002 (HLM 22.82), listed as a 16-inch steel pipe] FS Date: 7/12/2021

Levee crown.

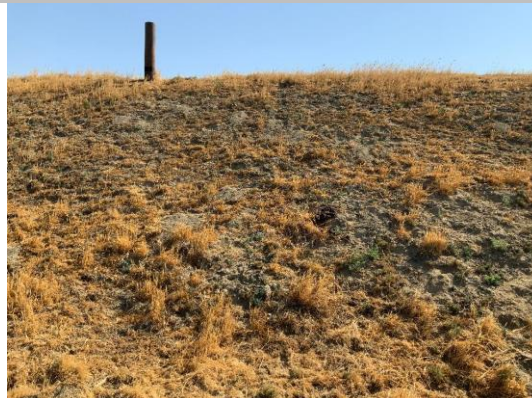
Photo 2 of 3 : UCIP\_FA\_2021\_70005\_101600.jpg

LS view: Slope from toe.

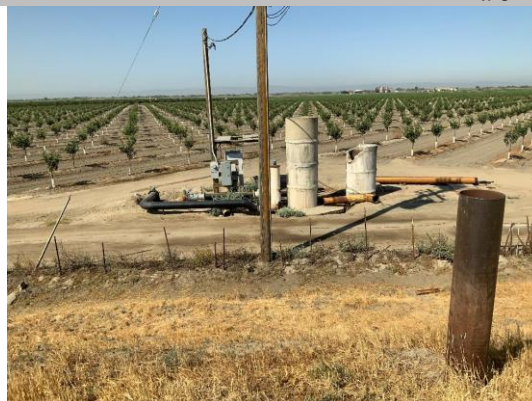
Photo 3 of 3 : UCIP\_FA\_2021\_70005\_101597.jpg

LS view: Risers and pumps off the toe from crown.

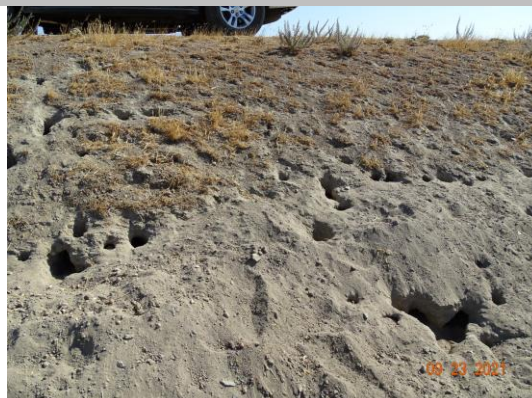
Photo 1 of 1 : FA\_2021\_NA0010\_124\_110\_20210929\_00223.jpg

LM Start	23.11	Rating **	M	Issue No.	110
LM End	23.11	Issue Type +	Ma	Location *	LS
Category	Earthen Levee			GPS Latitude/Longitude	
				Start	End
Item	Animal Control			37.087312 °	37.087312 °
				-120.536662 °	-120.536662 °
DWR ID	DWR_NA0010_06_f_2021_110				
Comment Code					
A3 : No rodents visible, but rodent burrows visible; need to backfill and compact or grout burrows.					
Inspector Comment

View of rodent burrows on the landside slope. (Fall 2021)

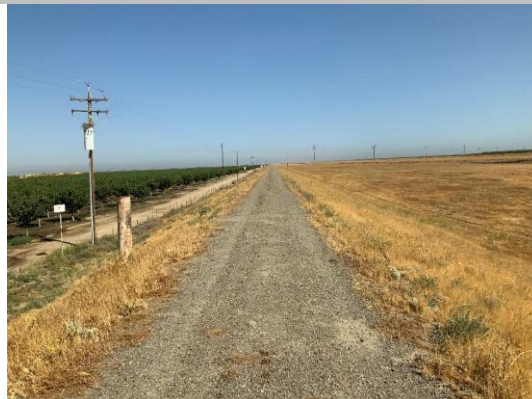
Photo 1 of 3 : UCIP\_FA\_2021\_70006\_101614.jpg

Comment Code						
Inspector Comment						
DS_ID:19879 FS_ID:70006 EP_NO: 13638 Repair Type: Non-Urgent EVAL Issue: Unauthorized Modification or Non-Compliant Permit Crossing Status: Found UCIP Comments: 07/12/2021 The record remains Non-Urgent. WS pump removed and wires cut. Large pieces of pipe appear to be out of place, crossing appears abandoned. Pump off LS toe behind fence is running for well water. Recommend contacting owner to confirm status of crossing. Erosion and instability underneath concrete pad meant for pump on the edge of the WS outlet channel. The UCIP inspection was completed with GEI staff, P. Espinoza. (H. Dunn – GEI) 04/17/2014 Need to contact owner to determine status. Crossing has been modified. (O. Magana - DWR UCIP) FIELD_STRUCT_DESC: 16-inch coated steel irrigation discharge pipe through the levee, 3.5 feet below the crown. Cutoff wall around the pipe at the center of the levee. Pump on the waterside (WS). Siphon breaker on the landside (LS) shoulder. Intake trench on the WS. (Plans to install a pump with a 16-inch pipeline over the levee authorized under Permit No. 13638, 1983 - Hamonds Ranch). [Additional Reference(s): DWR Levee Log, 2002 (HLM 23.92), listed as a 16-inch steel pipe] FS Date: 7/12/2021

Levee crown.

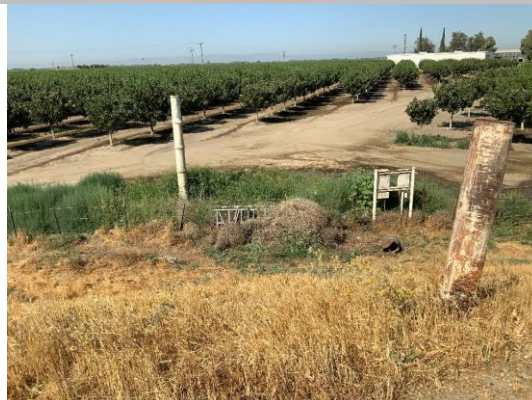
Photo 2 of 3 : UCIP\_FA\_2021\_70006\_101615.jpg

LS view: Toe from crown.

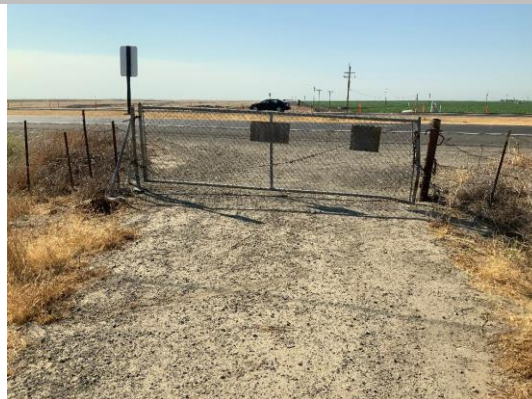
Photo 1 of 3 : UCIP\_FA\_2021\_68022\_101619.jpg

Comment Code						
Inspector Comment						
DS_ID:19880 FS_ID:68022 EP_NO: N/A Repair Type: Non-Urgent EVAL Issue: Pipe Not Found Crossing Status: Not Found UCIP Comments: 07/12/2021 The record is Non-Urgent. Pipe not found by visual inspection. No permit was found authorizing this encroachment. CVFPB will need to review crossing to determine owner. The UCIP inspection was completed with GEI staff, P. Espinoza. (H. Dunn – GEI) FIELD_STRUCT_DESC: Communications cable of an unknown size or material through the levee, at an unknown depth. [Additional Reference(s): DWR Levee Log, 2002 (HLM 24.36), listed as a communication cable]. FS Date: 7/12/2021

Levee crown.

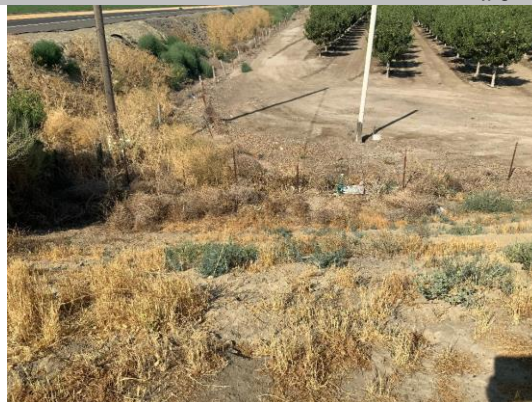
Photo 2 of 3 : UCIP\_FA\_2021\_68022\_101620.jpg

LS view: Toe from crown, no pipe visible.

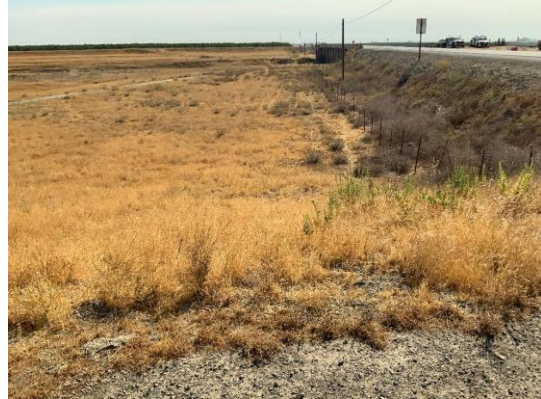
Photo 3 of 3 : UCIP\_FA\_2021\_68022\_101621.jpg

WS view: Toe from crown, no pipe visible.

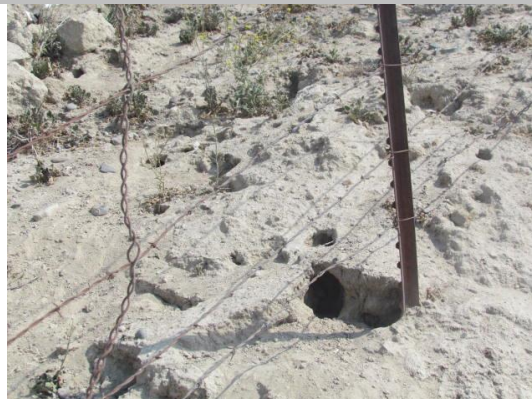
Photo 1 of 1 : FA\_2021\_NA0010\_124\_1208\_20210830\_00039.jpg

LM Start	26.13	Rating **	M	Issue No.	1208
LM End	26.13	Issue Type +	Ma	Location *	LS
Category	Earthen Levee			GPS Latitude/Longitude	
				Start	End
Item	Animal Control			37.054222 °	37.054222 °
				-120.500862 °	-120.500862 °
DWR ID	DWR_NA0010_06_s_2015_1208				
Comment Code					
A3 : No rodents visible, but rodent burrows visible; need to backfill and compact or grout burrows.					
Inspector Comment					
Noted several rodent holes next to and within rock revetment on landside slope.

Rodent holes on landward slope.

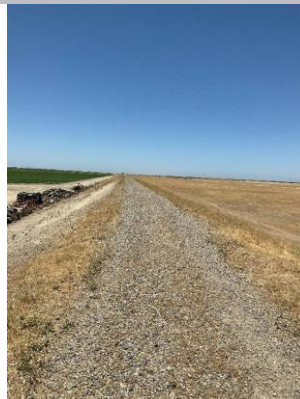
WS view: overview of WS. Pipe and flapgate visible on WS toe.

**Flood Control Project Maintenance  
Levee Inspections**

Comment Code						
Inspector Comment						
DS_ID:19568 FS_ID:70007 EP_NO: 13178 Repair Type: Non-Urgent EVAL Issue: Pipe Not Found Crossing Status: Not Found UCIP Comments: 06/24/2021 The record is Non-Urgent. Pipe not found by visual inspection. Confirm with owner on the status of this pipe. The UCIP inspection was completed with GEI staff, H.Dunn. (P.Espinoza – GEI) FIELD_STRUCT_DESC: 16-inch coated steel drainage discharge pipe through the levee, 2 feet below the crown. Electrical conduit through the levee. Metal cutoff wall around the pipe at the center of the levee. Siphon breaker on the apex of the pipe on the landside (LS) shoulder. Turbine pump on a concrete foundation. Holding basin on the waterside (WS). Service pole on the LS end. Riprap on the WS slope. Inlet channel from main river to WS levee toe. (Plans to place a turbine pump on the riverbank and a 16-inch discharge pipe through the levee authorized under Permit No. 13178, 1981 - Menefee Hill Ranch Company). FS Date: 6/24/2021 12:48:00 PM

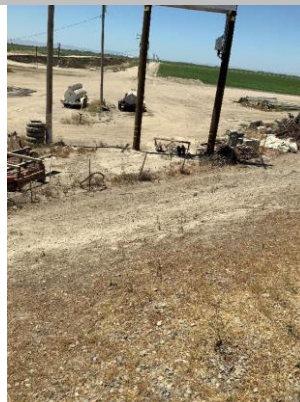
Photo 2 of 3 : UCIP\_FA\_2021\_70007\_103928.jpg

LS view: Toe from crown, no pipe visible.

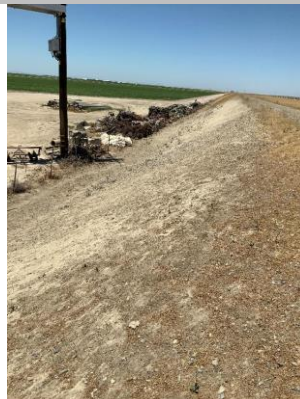
Photo 3 of 3 : UCIP\_FA\_2021\_70007\_103929.jpg

LS view: Slope from crown.

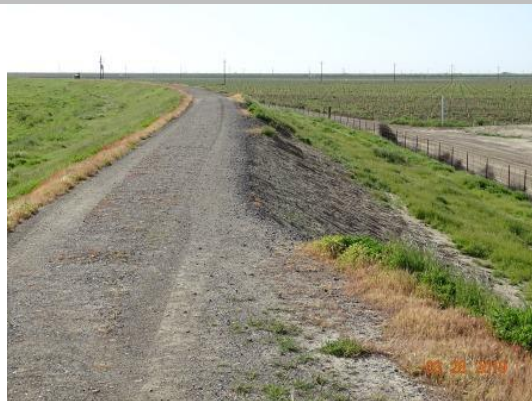
Photo 1 of 1 : FA\_2021\_NA0010\_124\_3\_20210830\_00001.jpg

LM Start	27.43	Rating **	M	Issue No.	3
LM End	27.99	Issue Type +	Ma	Location *	LS
Category	Earthen Levee			GPS Latitude/Longitude	
				Start	End
Item	Animal Control			37.036955 °	37.032762 °
				-120.484395 °	-120.481078 °
DWR ID	DWR_NA0010_06_s_2012_3				
Comment Code					
A2 : Repair the levee slope damaged by livestock and prevent large animal access.					
Inspector Comment					
Landside erosion and slope instability caused by livestock. Erosion greater than 3" in depth on landside slope. Levee crown has narrowed within this reach.

Looking south along landside slope. (Spring 2019)

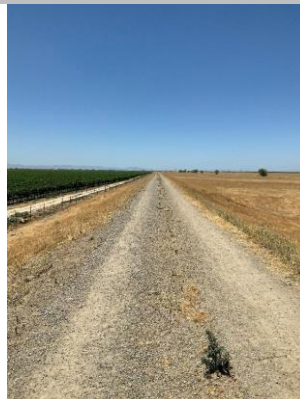
Photo 1 of 3 : UCIP\_FA\_2021\_70034\_103933.jpg

Comment Code						
Inspector Comment						
DS_ID:19881 FS_ID:70034 EP_NO: N/A Repair Type: Non-Urgent EVAL Issue: Safety Issue Crossing Status: Found UCIP Comments: 06/24/2021 The record remains Non-Urgent. WS inlet had sediment build up in pipe; recommend removal. Build up of debris in CMP riser on WS slope; recommend removal. WS CMP riser is missing lid, causing safety hazard. LS pipe outlet had elevated water levels around the headwall and pipe, limited ability to inspect closely. Unidentified pipe has been installed off 15 feet from the toe of LS headwall; does not affect crossing. No permit was found authorizing this encroachment. CVFPB will need to review crossing to determine owner. The UCIP inspection was completed with GEI staff, H.Dunn. (P.Espinoza – GEI) 04/10/2014 Dense vegetation limits the inspector's visibility to identify signs of pipe failure (leaks) along the slopes. Recommend removing vegetation along pipe alignment to conduct proper inspection of structure. (O. Magana - DWR UCIP) FIELD_STRUCT_DESC: 36-inch corrugated metal gravity irrigation pipe through the levee, 12.4 feet below the crown. Slide gate in a 48-inch corrugated metal pipe (CMP) riser on the waterside (WS) slope. Concrete U-shaped headwall on each end. Cobble pad on the landside (LS). [Additional Reference(s): DWR Levee Log, 2002 (HLM 29.34), listed as a 36-inch corrugated metal pipe (CMP). USACE San Joaquin O&M Manual, Unit 601 Part 1 (SJR601.1), 1967, Revised 25 May 2011, (HLM 29.34), listed as a 36-inch CMP]. FS Date: 6/24/2021 4:24:00 PM

View from levee crown.

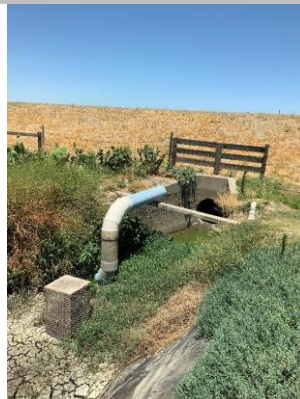
Photo 2 of 3 : UCIP\_FA\_2021\_70034\_103939.jpg

LS view: Concrete headwall and slope from toe. Unidentified pipes near entrance of outlet pipe.

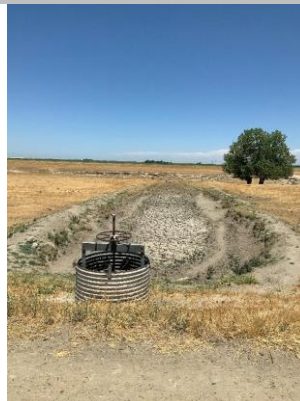
Photo 3 of 3 : UCIP\_FA\_2021\_70034\_103934.jpg

WS view: Toe from levee crown.

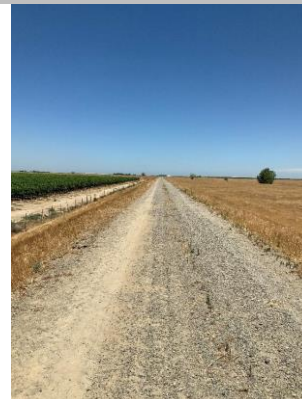
Photo 1 of 3 : UCIP\_FA\_2021\_69831\_103940.jpg

DS\_ID:19882  
FS\_ID:69831  
EP\_NO: N/A  
Repair Type: Non-Urgent  
EVAL Issue: Unauthorized Modification or Non-Compliant Permit  
Crossing Status: Found  
UCIP Comments: 06/24/2021 The record remains Non-Urgent. Altered crossing -- Two 12" plastic pipes going through LS outlet, recommend removing before flood season. No permit was found authorizing this encroachment. CVFPB will need to review crossing to determine owner. The UCIP inspection was completed with GEI staff, H.Dunn.  
(P.Espinoza – GEI) 04/10/2014 Altered crossing--steel pipe section on landward side and concrete pipe section on waterward side. Joints on waterward side separated. Need to contact owner to determine status. (O. Magana - DWR UCIP)  
FIELD\_STRUCT\_DESC: [Rodunder Siphon Structure] 48-inch reinforced concrete irrigation siphon pipe through the levee, 14.5 feet below the crown. Concrete U-shaped headwall on the outlet structure on the landside (LS) end. Slide gate mounted on the headwall.

View of levee crown.

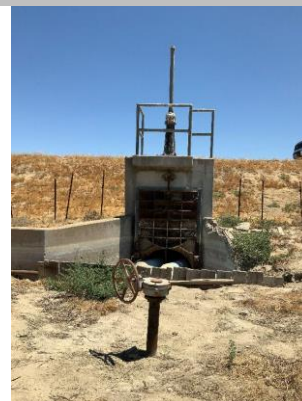
Photo 2 of 3 : UCIP\_FA\_2021\_69831\_103941.jpg

LS view: Concrete headwall, slidegate, and slope at toe.

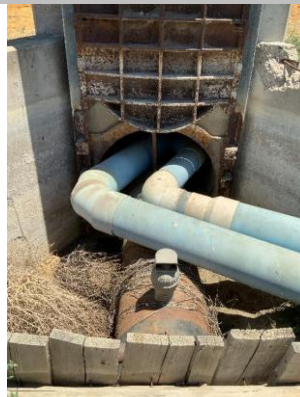
Photo 3 of 3 : UCIP\_FA\_2021\_69831\_103942.jpg

LS view: Closeup of slide gate and unauthorized 12" pipes going through outlet pipe at toe, 1 of 2 photos.

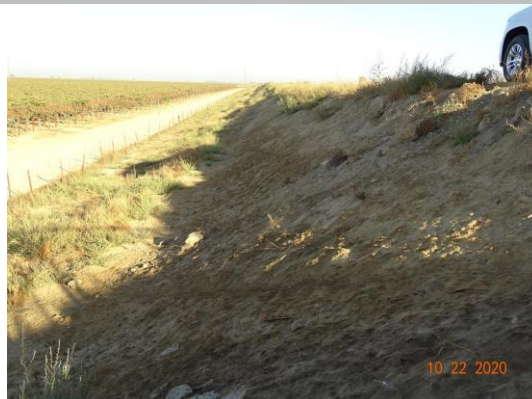
Photo 1 of 1 : FA\_2021\_NA0010\_124\_1207\_20210830\_00038.jpg

LM Start	30.81	Rating **	M	Issue No.	1207
LM End	31.06	Issue Type +	Ma	Location *	LS
Category	Earthen Levee			GPS Latitude/Longitude	
				Start	End
Item	Animal Control			37.021615 °	37.018428 °
				-120.437587 °	-120.435378 °
DWR ID	DWR_NA0010_06_s_2015_1207				
Comment Code					
A2 : Repair the levee slope damaged by livestock and prevent large animal access.					
Inspector Comment					
Landside erosion greater than 1" in depth and greater than 3" in length. Erosion is caused by livestock traffic.

Looking upstream at livestock damage to the landside slope. (Fall 2020)
