## Flood Control Project Maintenance Levee Inspections

### Fall 2021 Levee Maintenance Deficiency Summary Report

#### San Joaquin River Basin

NA0010 Lower San Joaquin Levee District	Overall LMA Rating	Total LMA Miles							
	U	191.27							
Rated Item	Maintenance Deficiency				Enforcement		Design & System Obsolescence		
	M Miles	U Miles	M + 4U Miles	Threshold %	M Miles	U Miles	M Miles	U Miles	
<i>Earthen Levee</i>									
Vegetation	47.00	9.57	85.28	44.59%					
Trim / Thin Trees	0.10		0.10	0.05%					
Encroachments	0.23	0.02	0.31	0.16%	9.29	0.59			
Animal Control	7.67	2.19	16.43	8.59%					
Slope Stability	0.05	0.01	0.09	0.05%					
Erosion / Bank Caving	0.13	0.81	3.37	1.76%					
Crown Surface / Depressions / Rutting	0.01		0.01	0.01%					
Repair Gates	0.02	0.02	0.10	0.05%					
<i>Rivers, Channels &amp; Designated Floodways</i>									
Encroachments					0.01	0.01			
<i>Supplemental</i>									
DWR Erosion Survey	0.12	0.17	0.80	0.42%					
DWR UCIP Field Study					1.29	0.05			
DWR UCIP LMA Responsibility									
<i>LMA Totals:</i>	55.33	12.79	106.49	55.67%	10.59	0.65	0.00	0.00

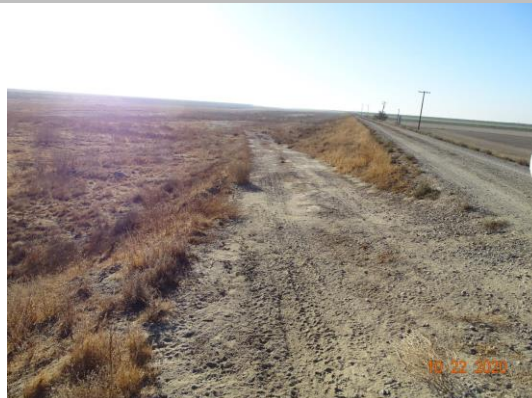
Photo 1 of 1 : FA\_2021\_NA0010\_124\_80\_20210830\_00016.jpg

LM Start	31.10	Rating **	U	Issue No.	80
LM End	31.10	Issue Type +	En	Location *	WS
Category	Earthen Levee			GPS Latitude/Longitude	
				Start	End
Item	Encroachments			37.017907 °	37.017907 °
				-120.434970 °	-120.434970 °
DWR ID	DWR_NA0010_06_s_2017_80				
Comment Code					
RA : Ramp					
Inspector Comment					
Farmer installed ramp on waterside slope.

Looking upstream at ramp on the waterside slope. (Fall 2020)

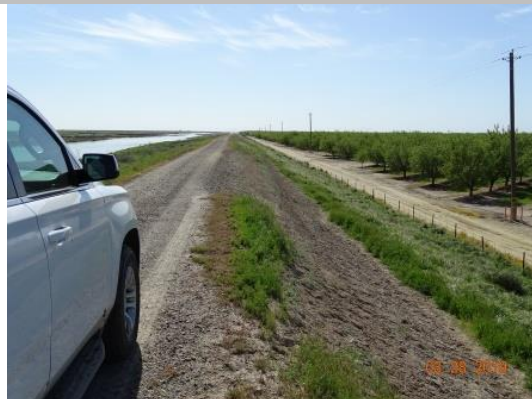
Photo 1 of 1 : FA\_2021\_NA0010\_124\_129\_20210830\_00037.jpg

LM Start	32.50	Rating **	M	Issue No.	129
LM End	32.88	Issue Type +	Ma	Location *	LS
Category	Earthen Levee			GPS Latitude/Longitude	
				Start	End
Item	Animal Control			37.001898 °	36.997745 °
				-120.419861 °	-120.415197 °
DWR ID	DWR_NA0010_06_s_2019_129				
Comment Code					
A2 : Repair the levee slope damaged by livestock and prevent large animal access.					
Inspector Comment					
Slope damage from livestock. Damage is beginning to erode into levee crown.

Erosion from animal activity along the landside slope. (Spring 2019)

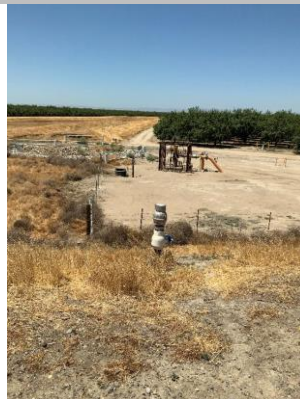
Photo 1 of 3 : UCIP\_FA\_2021\_69833\_103947.jpg

DS\_ID:19883  
FS\_ID:69833  
EP\_NO: 6416-C  
Repair Type: Non-Urgent  
EVAL Issue: Limited Inspection/No UCIP Evaluation  
Crossing Status: Found  
UCIP Comments: 06/24/2021 The record remains Non-Urgent. Limited inspection of LS due to barbed wire and accessibility issues. The UCIP inspection was completed with GEI staff, H.Dunn. (P.Espinoza – GEI)

LS view: Siphon breaker located on slope. Additional structures visible off the toe.

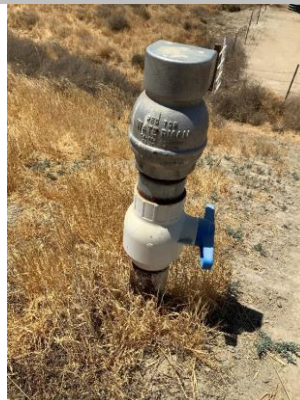
Photo 2 of 3 : UCIP\_FA\_2021\_69833\_103948.jpg

LS view: Closeup of siphon breaker on the apex of the pipe on shoulder.

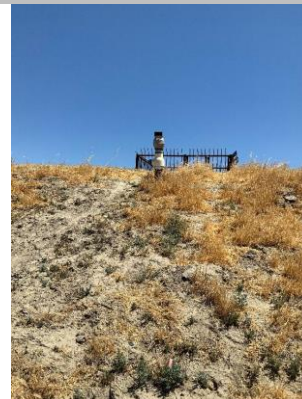
Photo 3 of 3 : UCIP\_FA\_2021\_69833\_103949.jpg

LS view: Slope from toe.

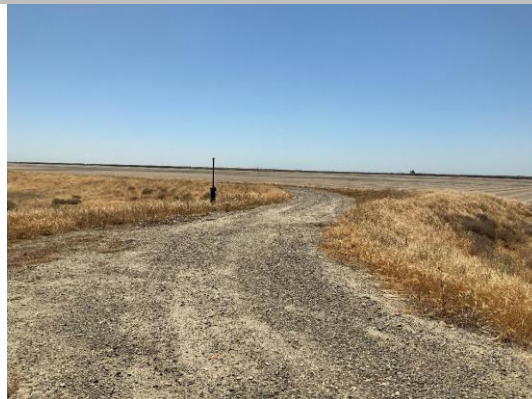
Photo 1 of 3 : UCIP\_FA\_2021\_69835\_103953.jpg

DS\_ID:19813  
FS\_ID:69835  
EP\_NO: N/A  
Repair Type: Non-Urgent  
EVAL Issue: Unauthorized Encroachment, installed decades prior  
Crossing Status: Found  
UCIP Comments: 06/24/2021 The record remains Non-Urgent. No permit was found authorizing this encroachment. Crossing appears in good condition. CVFPB will need to review crossing to determine owner. The UCIP inspection was completed with GEI staff, H.Dunn. (P.Espinoza – GEI) 04/10/2014 Dense vegetation limits the inspector's visibility to identify signs of pipe failure (leaks) along the slope. Recommend removing vegetation along pipe alignment to conduct proper inspection of structure and appurtenances. High vegetation along crossing alignment--recommend removing vegetation along pipe crossing. (O. Magana - DWR UCIP)  
FIELD\_STRUCT\_DESC: [Fresno River Irrigation Structure] 48-inch by 72-inch reinforced concrete box gravity irrigation culvert through the levee, 15.1 feet below the crown. Slide gate in a concrete riser in the waterside (WS) slope. Concrete U-shaped headwall on each end. Landside (LS) channel cobble revetted for 8 feet. [Additional Reference(s): DWR Levee Log, 2002 (HLM 35.33), listed as a 48-inch by 72-inch reinforced concrete box culvert (RCBC). USACE San Joaquin O&M Manual, Unit 601 Part 1 (SJR601.1), 1967, Revised 25 May 2011, (HLM 35.33), listed as a 6-foot by 4-foot RCBC, known as the Fresno River Irrigation Structure].

View of levee crown.

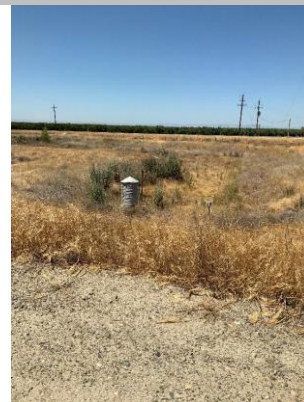
Photo 2 of 3 : UCIP\_FA\_2021\_69835\_103954.jpg

LS view of slope to toe.

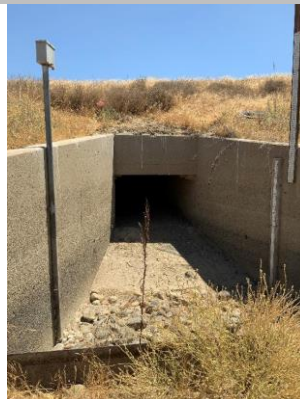
Photo 3 of 3 : UCIP\_FA\_2021\_69835\_103958.jpg

LS view: concrete headwall and inlet.

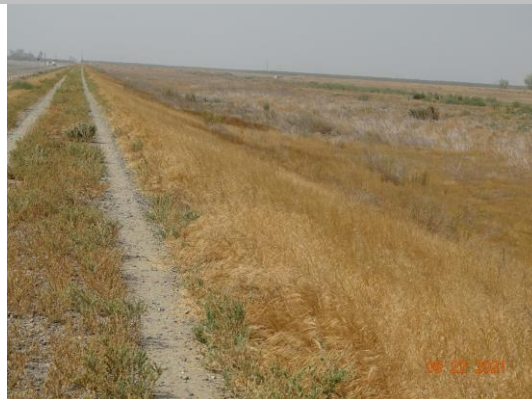
Photo 1 of 1 : FA\_2021\_NA0010\_124\_96\_20211005\_00225.jpg

LM Start	35.77	Rating **	M	Issue No.	96
LM End	36.44	Issue Type +	Ma	Location *	WS
Category	Earthen Levee			GPS Latitude/Longitude	
				Start	End
Item	Vegetation			36.974390 °	36.974349 °
				-120.375875 °	-120.363680 °
DWR ID	DWR_NA0010_06_f_2021_96				
Comment Code					
V1 : Control annual grass and weeds on the levee slopes and easements.					
Inspector Comment

View of vegetation along the waterside slope. (Fall 2021)

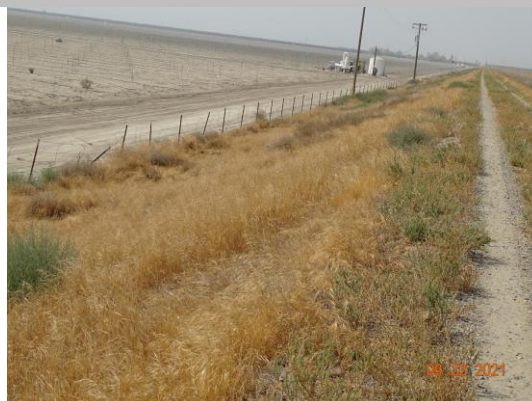
Photo 1 of 1 : FA\_2021\_NA0010\_124\_88\_20211005\_00226.jpg

LM Start	35.78	Rating **	M	Issue No.	88
LM End	36.44	Issue Type +	Ma	Location *	LS
Category	Earthen Levee			GPS Latitude/Longitude	
				Start	End
Item	Vegetation			36.974393 °	36.974352 °
				-120.375605 °	-120.363677 °
DWR ID	DWR_NA0010_06_f_2021_88				
Comment Code					
V1 : Control annual grass and weeds on the levee slopes and easements.					
Inspector Comment

Looking downstream along the landside slope. (Fall 2021)

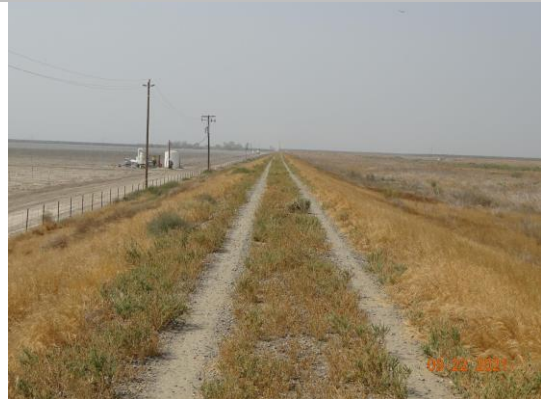
Photo 1 of 1 : FA\_2021\_NA0010\_124\_106\_20211005\_00227.jpg

LM Start	35.97	Rating **	M	Issue No.	106
LM End	36.39	Issue Type +	Ma	Location *	CR
Category	Earthen Levee			GPS Latitude/Longitude	
				Start	End
Item	Vegetation			36.974404 °	36.974431 °
				-120.372291 °	-120.364600 °
DWR ID	DWR_NA0010_06_f _ 2021_106				
Comment Code					
V9 : Keep the crown roadway free of vegetation.					
Inspector Comment

Looking downstream along the levee crown. (Fall 2021)

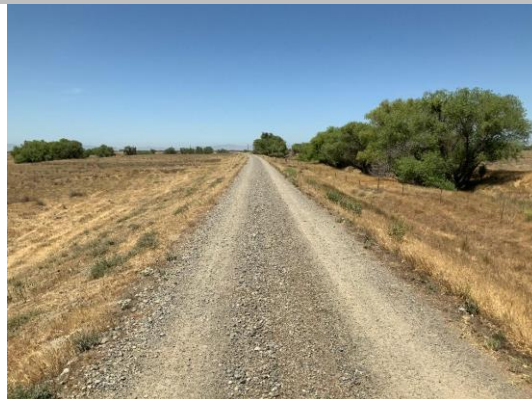
Photo 1 of 3 : UCIP\_FA\_2021\_67293\_99437.jpg

Comment Code						
Inspector Comment						
DS_ID:19892 FS_ID:67293 EP_NO: N/A Repair Type: Non-Urgent EVAL Issue: Unauthorized Encroachment, installed decades prior Crossing Status: Found UCIP Comments: 06/2/2021 Record remains Non-Urgent. DWR DMP internal inspection has not found pipe integrity issues. LOF of crossing is less or equal to 4.0. Recommend next video inspection in 5 years. No permit was found authorizing this encroachment. CVFPB will need to review crossing to determine owner. The UCIP inspection was completed with GEI staff, P. Espinoza. (H. Dunn – GEI) 07/20/2016 Inlet blocked off by wooden board. Dense vegetation limits the inspector's visibility to identify signs of pipe failure (leaks) along WS and LS. Crossing downgraded from Urgent to Non-Urgent. (O. Magana - DWR UCIP)04/15/2014 Flapgate partially blocked by soil buildup at WS toe. (W. Wylie - DWR UCIP) FIELD_STRUCT_DESC: 24-inch corrugated metal gravity drainage pipe through the levee, 10.8 feet below the crown. Flap gate on the waterside (WS) end. Concrete headwall on the landside (LS) end. Concrete U-shaped headwall on the WS end. [Additional Reference(s): DWR Levee Log, 2002 (HLM 0.08), listed as a 24-inch corrugated metal pipe (CMP). USACE San Joaquin O&M Manual, Unit 601 Part 1 (SJR601.1), 1967, (HLM 0.07), listed as a 24-inch CMP]. FS Date: 6/2/2021

Levee crown looking downstream.

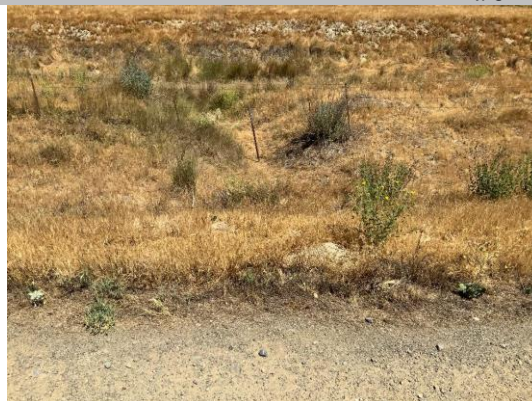
Photo 2 of 3 : UCIP\_FA\_2021\_67293\_99440.jpg

LS view: Toe from crown.

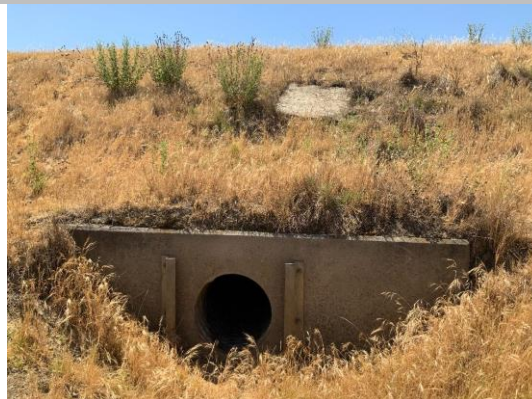
Photo 3 of 3 : UCIP\_FA\_2021\_67293\_99441.jpg

LS view: Slope and headwall at toe.

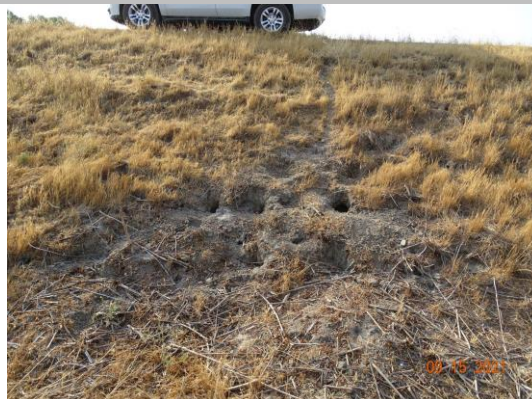
Photo 1 of 1 : FA\_2021\_NA0010\_125\_17\_20211005\_00043.jpg

LM Start	0.10	Rating **	M	Issue No.	17
LM End	0.10	Issue Type +	Ma	Location *	LS
Category	Earthen Levee			GPS Latitude/Longitude	
				Start	End
Item	Animal Control			37.256017 °	37.256017 °
				-120.770636 °	-120.770636 °
DWR ID	DWR_NA0010_07_f_2021_17				
Comment Code					
A3 : No rodents visible, but rodent burrows visible; need to backfill and compact or grout burrows.					
Inspector Comment

View of rodent holes in the landside slope. (Fall 2021)

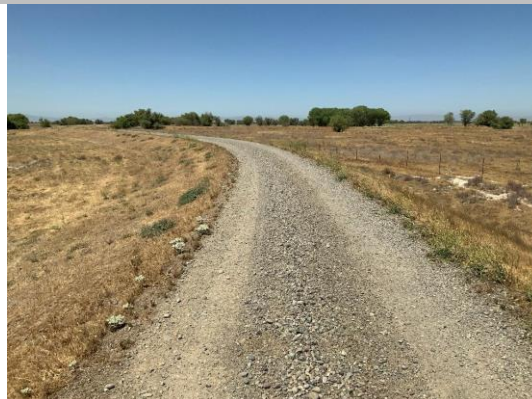
Photo 1 of 3 : UCIP\_FA\_2021\_67294\_99444.jpg

DS\_ID:19893  
FS\_ID:67294  
EP\_NO: N/A  
Repair Type: Non-Urgent  
EVAL Issue: Unauthorized Encroachment, installed decades prior  
Crossing Status: Found  
UCIP Comments: 06/2/2021 The record has been upgraded from No Action Needed to Non-Urgent. DWR DMP internal inspection has not found pipe integrity issues. LOF of crossing is less or equal to 4.0. Recommend next video inspection in 5 years. No permit was found authorizing this encroachment. CVFPB will need to review crossing to determine owner. The UCIP inspection was completed with GEI staff, P. Espinoza. (H. Dunn – GEI)  
FIELD\_STRUCT\_DESC: 24-inch corrugated metal gravity drainage pipe through the levee, 11.1 feet below the crown. Flap gate on the waterside (WS) end. Concrete headwall on the landside (LS) end. Concrete U-shaped headwall on the WS end. [Additional Reference(s): DWR Levee Log, 2002 (HLM 0.34), listed as a 24-inch corrugated metal pipe (CMP). USACE San Joaquin O&M Manual, Unit 601 Part 1 (SJR601.1), 1967, (HLM 0.33), listed as a 24-inch CMP].

Levee crown looking downstream.

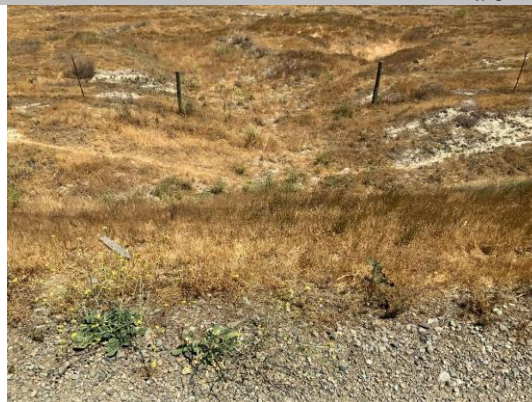
Photo 2 of 3 : UCIP\_FA\_2021\_67294\_99447.jpg

LS view: Toe from crown.

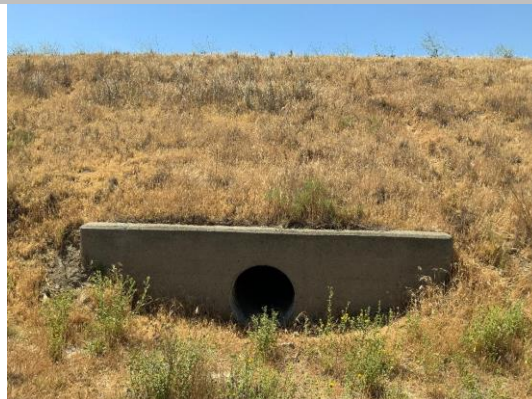
Photo 3 of 3 : UCIP\_FA\_2021\_67294\_99448.jpg

LS view: Slope and headwall at toe.

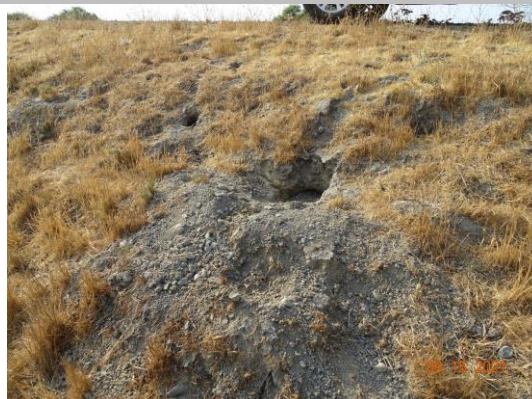
Photo 1 of 1 : FA\_2021\_NA0010\_125\_29\_20211005\_00044.jpg

LM Start	0.40	Rating **	M	Issue No.	29
LM End	0.50	Issue Type +	Ma	Location *	LS
Category	Earthen Levee			GPS Latitude/Longitude	
				Start	End
Item	Animal Control			37.257786 °	37.258722 °
				-120.765855 °	-120.764867 °
DWR ID	DWR_NA0010_07_s_2012_29				
Comment Code					
A3 : No rodents visible, but rodent burrows visible; need to backfill and compact or grout burrows.					
Inspector Comment					
Several rodent holes were noted on the landside and waterside slope and shoulder.

Looking at representative rodent hole in the landside slope. (Fall 2021)

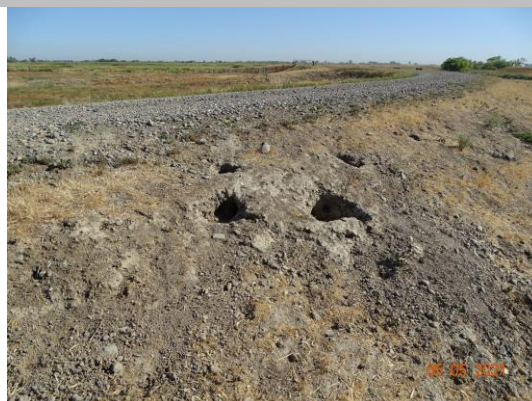
Photo 1 of 1 : FA\_2021\_NA0010\_125\_22\_20210830\_00008.jpg

LM Start	0.44	Rating **	M	Issue No.	22
LM End	0.44	Issue Type +	Ma	Location *	WS
Category	Earthen Levee			GPS Latitude/Longitude	
				Start	End
Item	Animal Control			37.257894 °	37.257894 °
				-120.765231 °	-120.765231 °
DWR ID	DWR_NA0010_07_s_2021_22				
Comment Code					
A3 : No rodents visible, but rodent burrows visible; need to backfill and compact or grout burrows.					
Inspector Comment

View of rodent burrows in the waterside slope and shoulder. (Spring 2021)

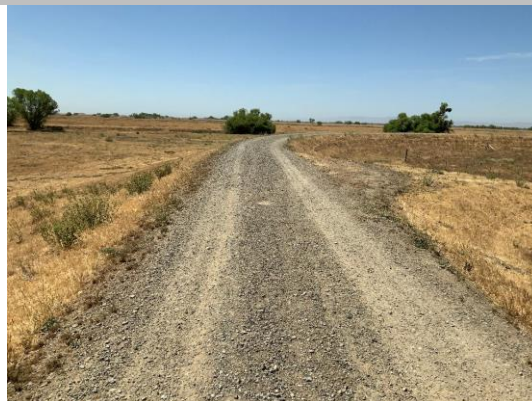
Photo 1 of 3 : UCIP\_FA\_2021\_67295\_99452.jpg

Comment Code					
Inspector Comment					
DS_ID:19894 FS_ID:67295 EP_NO: N/A Repair Type: Non-Urgent EVAL Issue: Safety Issue Crossing Status: Found UCIP Comments: 06/2/2021 Record remains Non-Urgent. No cover over the WS metal riser. There is debris and wood pallets within the riser that may prevent the ability for the slidegate to be opened or water to flow through, recommend cleaning out. DWR DMP internal inspection has not found pipe integrity issues. LOF of crossing is less or equal to 4.0. Recommend next video inspection in 5 years. No permit was found authorizing this encroachment. CVFPB will need to review crossing to determine owner. The UCIP inspection was completed with GEI staff, P. Espinoza. (H. Dunn – GEI) 04/15/2014 Slide gate not operable, but left in closed position. Need to reinstall covers over slide gate standpipe. (W. Wylie - DWR UCIP) FIELD_STRUCT_DESC: 36-inch corrugated metal gravity drainage pipe through the levee, 9.7 feet below the crown. Slide gate in a 48-inch corrugated metal pipe (CMP) riser on the landside (LS) slope. Concrete U-shaped headwall on the LS end. Inlet channel cobble revetted. Dilapidated wooden pier on the waterside (WS). WS slope and outlet ditch cobble revetted. [Additional Reference(s): DWR Levee Log, 2002 (HLM 0.49), listed as a 36-inch corrugated metal pipe (CMP). USACE San Joaquin O&M Manual, Unit 601 Part 1 (SJR601.1), 1967, (HLM 0.49), listed as a 36-inch CMP]. FS Date: 6/2/2021

Levee crown looking downstream.

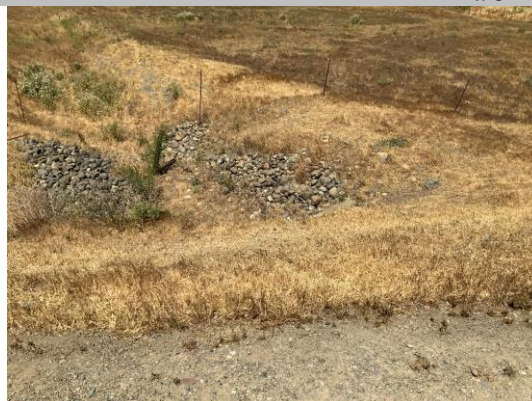
Photo 2 of 3 : UCIP\_FA\_2021\_67295\_99449.jpg

LS view: Toe from crown.

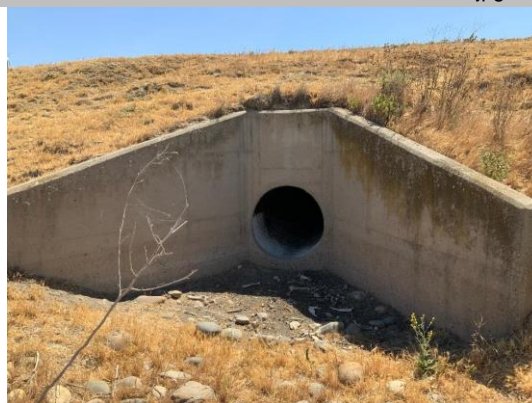
Photo 3 of 3 : UCIP\_FA\_2021\_67295\_99450.jpg

LS view: Slope and headwall at toe.

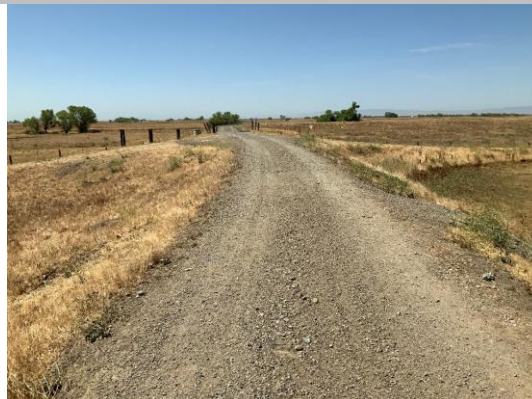
Photo 1 of 3 : UCIP\_FA\_2021\_67932\_99460.jpg

DS\_ID:19895  
FS\_ID:67932  
EP\_NO: N/A  
Repair Type: Non-Urgent  
EVAL Issue: Unauthorized Modification or Non-Compliant Permit  
Crossing Status: Found  
UCIP Comments: 06/2/2021 The record has been upgraded from No Action Needed to Non-Urgent. DWR DMP internal inspection has not found pipe integrity issues. LOF of crossing is less or equal to 4.0. Recommend next video inspection in 5 years. There are plywood barriers on both WS and LS pipe ends, but no flapgate on either, and flapgate removed on WS. No permit was found authorizing this encroachment. CVFPB will need to review crossing to determine owner. The UCIP inspection was completed with GEI staff, P. Espinoza. (H. Dunn – GEI)  
FIELD\_STRUCT\_DESC: 24-inch corrugated metal gravity drainage pipe through the levee, 9 feet below the crown. Flap gate on the waterside (WS) end. Concrete headwall with a wooden weir at the inlet on the landside (LS) toe. Concrete U-shaped headwall on the WS toe. [Additional Reference(s): DWR Levee Log, 2002 (HLM 0.53), listed as a 24-inch corrugated metal pipe (CMP). USACE San Joaquin O&M Manual, Unit 601 Part 1 (SJR601.1), 1967, (HLM 0.53), listed as a 24-inch CMP].

Levee crown looking downstream.

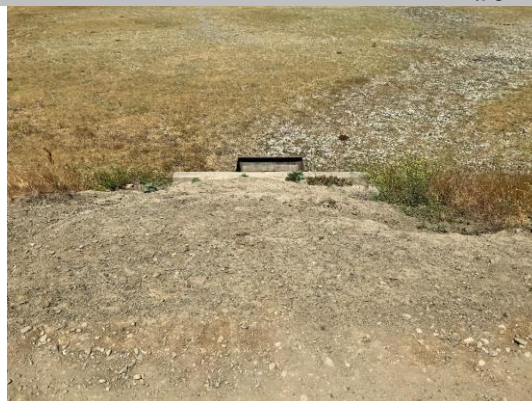
Photo 2 of 3 : UCIP\_FA\_2021\_67932\_99464.jpg

LS view: Headwall visible at toe from crown.

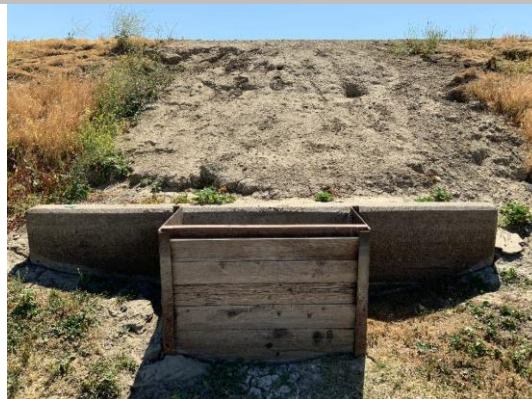
Photo 3 of 3 : UCIP\_FA\_2021\_67932\_99459.jpg

LS view: Slope and headwall at toe.

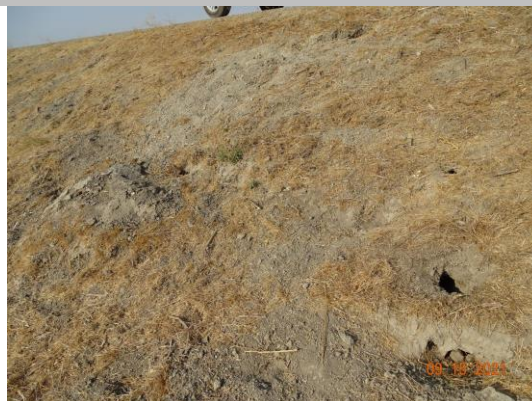
Photo 1 of 1 : FA\_2021\_NA0010\_125\_23\_20211005\_00045.jpg

LM Start	0.56	Rating **	M	Issue No.	23
LM End	0.56	Issue Type +	Ma	Location *	WS
Category	Earthen Levee			GPS Latitude/Longitude	
				Start	End
Item	Animal Control			37.259579 °	37.259579 °
				-120.764687 °	-120.764687 °
DWR ID	DWR_NA0010_07_f_2021_23				
Comment Code					
A1 : Exterminate rodents and backfill and compact or grout burrows.					
Inspector Comment

Looking at rodent burrows along the waterside slope. (Fall 2021)

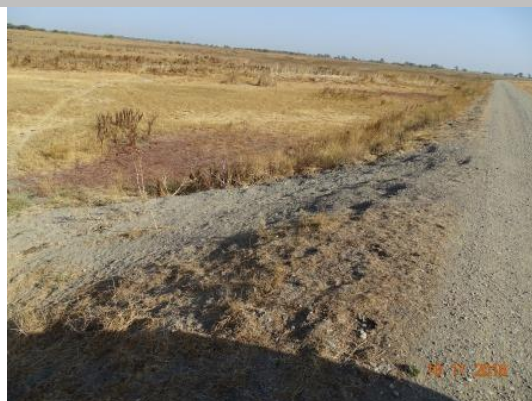
Photo 1 of 1 : FA\_2021\_NA0010\_125\_19\_20210830\_00006.jpg

LM Start	0.70	Rating **	M	Issue No.	19
LM End	0.70	Issue Type +	Ma	Location *	LS
Category	Earthen Levee			GPS Latitude/Longitude	
				Start	End
Item	Animal Control			37.261337 °	37.261337 °
				-120.763303 °	-120.763303 °
DWR ID	DWR_NA0010_07_f_2018_19				
Comment Code					
A2 : Repair the levee slope damaged by livestock and prevent large animal access.					
Inspector Comment					
There is livestock damage to the landside slope.

Damage to landside slope from livestock. (Fall 2018)

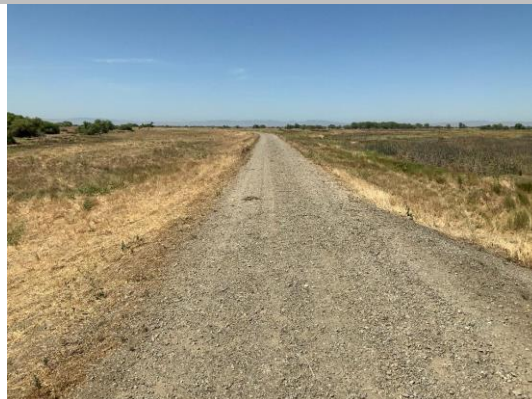
Photo 1 of 3 : UCIP\_FA\_2021\_67933\_99467.jpg

DS\_ID:19896  
FS\_ID:67933  
EP\_NO: N/A  
Repair Type: Non-Urgent  
EVAL Issue: Limited Inspection/No UCIP Evaluation  
Crossing Status: Found  
UCIP Comments: 06/2/2021 Record remains Non-Urgent. No permit was found authorizing this encroachment. CVFPB will need to review crossing to determine owner. Limited inspection due to water flowing through the pipe during inspection. At the time of inspection, the wooden flashboards were not in place on the LS end. The UCIP inspection was completed with GEI staff, P. Espinoza. (H. Dunn – GEI)

Levee crown looking downstream.

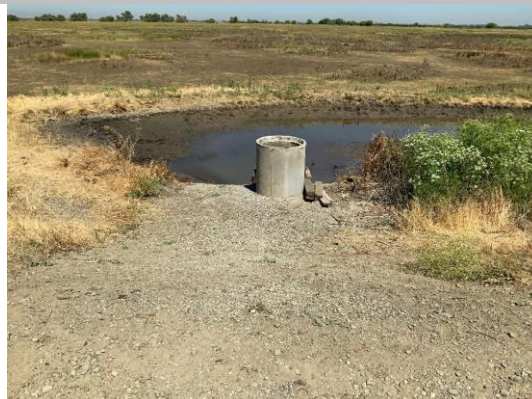
Photo 2 of 3 : UCIP\_FA\_2021\_67933\_99471.jpg

LS view: Riser visible at toe from crown.

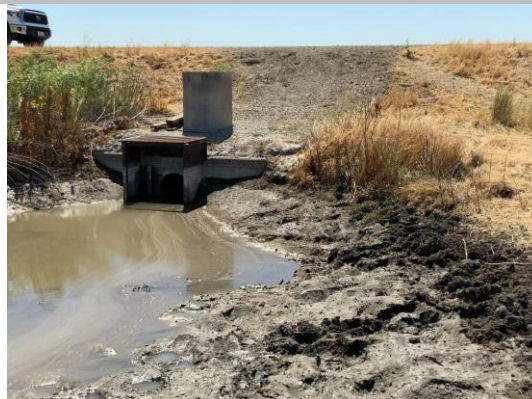
Photo 3 of 3 : UCIP\_FA\_2021\_67933\_99465.jpg

LS view: Slope and riser visible at toe.

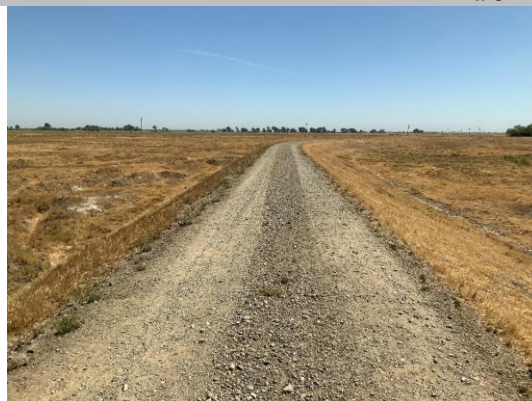
Photo 1 of 3 : UCIP\_FA\_2021\_67298\_99474.jpg

DS\_ID:19897  
FS\_ID:67298  
EP\_NO: N/A  
Repair Type: Non-Urgent  
EVAL Issue: Unauthorized Encroachment, installed decades prior  
Crossing Status: Found  
UCIP Comments: 06/2/2021 The record has been upgraded from No Action Needed to Non-Urgent. DWR DMP internal inspection has not found pipe integrity issues. LOF of crossing is less or equal to 4.0. Recommend next video inspection in 5 years. No permit was found authorizing this encroachment. CVFPB will need to review crossing to determine owner. The UCIP inspection was completed with GEI staff, P. Espinoza. (H. Dunn – GEI)  
FIELD\_STRUCT\_DESC: 24-inch corrugated metal gravity drainage pipe through the levee, 11.5 feet below the crown. Flap gate on the waterside (WS) end. Concrete headwall on the landside (LS) end. Concrete U-shaped headwall on the WS end. [Additional Reference(s): DWR Levee Log, 2002 (HLM 0.94), listed as a 24-inch corrugated metal pipe (CMP). USACE San Joaquin O&M Manual, Unit 601 Part 1 (SJR601.1), 1967, (HLM 0.94), listed as a 24-inch CMP].

Levee crown looking downstream.

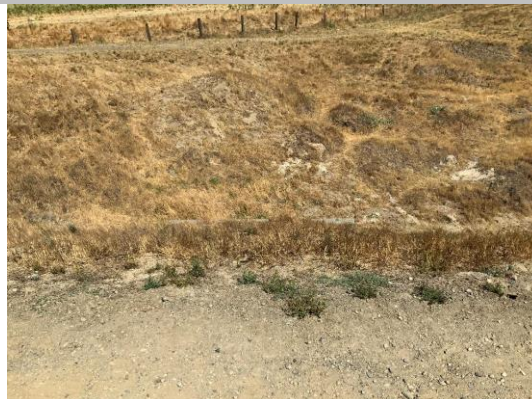
Photo 2 of 3 : UCIP\_FA\_2021\_67298\_99478.jpg

LS view: Toe from crown.

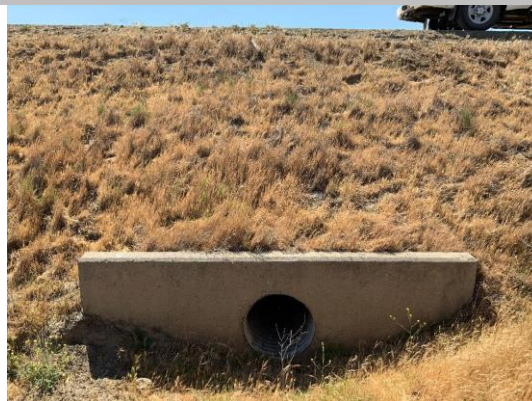
Photo 3 of 3 : UCIP\_FA\_2021\_67298\_99472.jpg

LS view: Slope and headwall at toe.

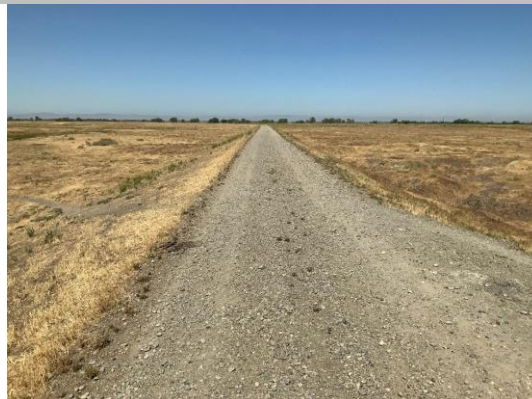
Photo 1 of 3 : UCIP\_FA\_2021\_67299\_99481.jpg

DS\_ID:19898  
FS\_ID:67299  
EP\_NO: N/A  
Repair Type: Non-Urgent  
EVAL Issue: Unauthorized Encroachment, installed decades prior  
Crossing Status: Found  
UCIP Comments: 06/2/2021 The record has been upgraded from No Action Needed to Non-Urgent. No permit was found authorizing this encroachment. CVFPB will need to review crossing to determine owner. The UCIP inspection was completed with GEI staff, P. Espinoza. (H. Dunn – GEI)  
FIELD\_STRUCT\_DESC: 48-inch corrugated metal gravity drainage pipe through the levee, 14.6 feet below the crown. Flap gate on the waterside (WS) end. Concrete U-shaped headwall on each end.  
[Additional Reference(s): DWR Levee Log, 2002 (HLM 1.17), listed as a 48-inch corrugated metal pipe (CMP). USACE San Joaquin O&M Manual, Unit 601 Part 1 (SJR601.1), 1967, (HLM 1.17), listed as a 48-inch CMP].  
FS Date: 6/2/2021

Levee crown looking downstream.

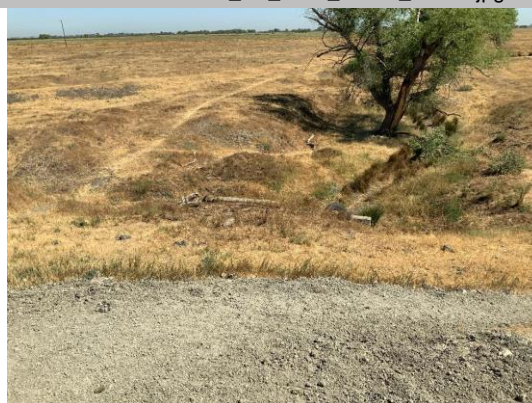
Photo 2 of 3 : UCIP\_FA\_2021\_67299\_99482.jpg

LS view: Toe from crown.

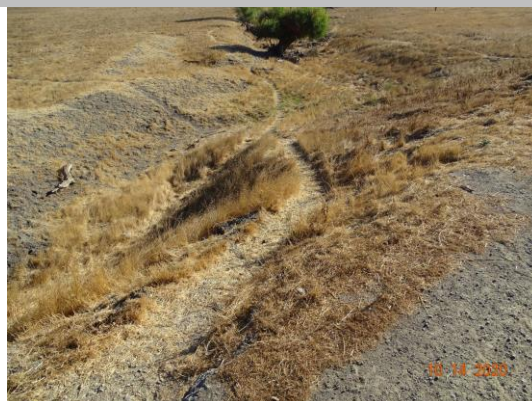
Photo 1 of 1 : FA\_2021\_NA0010\_125\_16\_20210830\_00004.jpg

LM Start	1.49	Rating **	A/W	Issue No.	16
LM End	1.49	Issue Type +	Ma	Location *	LS
Category	Earthen Levee			GPS Latitude/Longitude	
				Start	End
Item	Animal Control			37.263999 °	37.263999 °
				-120.750854 °	-120.750854 °
DWR ID	DWR_NA0010_07_f_2017_16				
Comment Code					
A2 : Repair the levee slope damaged by livestock and prevent large animal access.					
Inspector Comment					
Monitor the slope damaged by animal traffic.

Cattle trail on the landside slope. (Fall 2020)

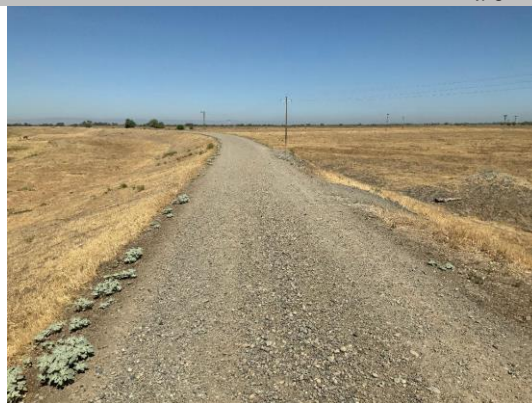
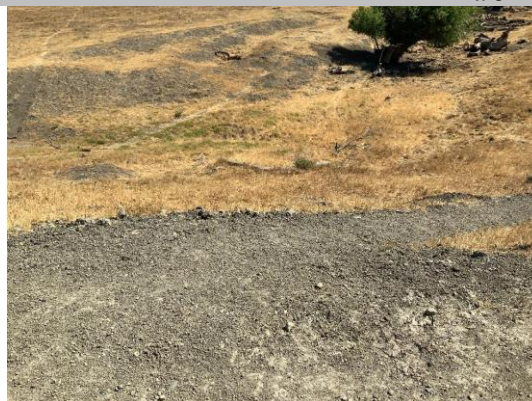
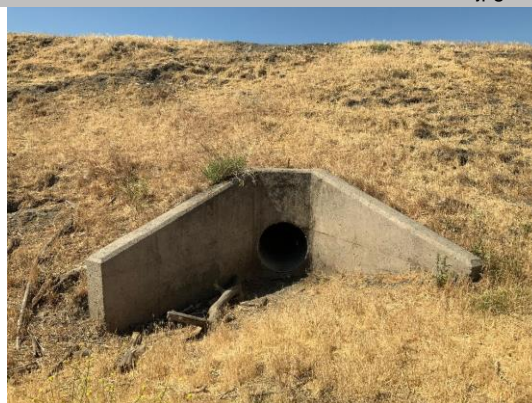
LM Start	1.50	Rating **	M	Issue No.	37	
LM End	1.50	Issue Type +	Ma	Location *		
Category	Supplemental			GPS Latitude/Longitude		
				Start	End	
Item	DWR UCIP LMA Responsibility			37.263917 °	37.263917 °	
				-120.750694 °	-120.750694 °	
DWR ID	19902

Comment Code						
Inspector Comment						
DS_ID:19902 FS_ID:67300 EP_NO: N/A Repair Type: Non-Urgent EVAL Issue: Unauthorized Encroachment, installed decades prior Crossing Status: Found UCIP Comments: 06/2/2021 The record has been upgraded from No Action Needed to Non-Urgent. DWR DMP internal inspection has not found pipe integrity issues. LOF of crossing is less or equal to 4.0. Recommend next video inspection in 5 years. No permit was found authorizing this encroachment. CVFPB will need to review crossing to determine owner. The UCIP inspection was completed with GEI staff, P. Espinoza. (H. Dunn – GEI) FIELD_STRUCT_DESC: 24-inch corrugated metal gravity drainage pipe through the levee, 14 feet below the crown. Flap gate on the waterside (WS) end. Concrete U-shaped headwall on each end. [Additional Reference(s): DWR Levee Log, 2002 (HLM 1.51), listed as a 24-inch corrugated metal pipe (CMP). USACE San Joaquin O&M Manual, Unit 601 Part 1 (SJR601.1), 1967, (HLM 1.51), listed as a 24-inch CMP]. FS Date: 6/2/2021

Levee crown looking downstream.

LS view: Toe from crown.

LS view: Slope and headwall at toe.

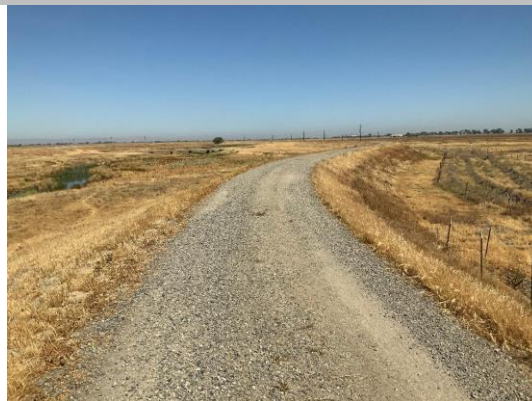
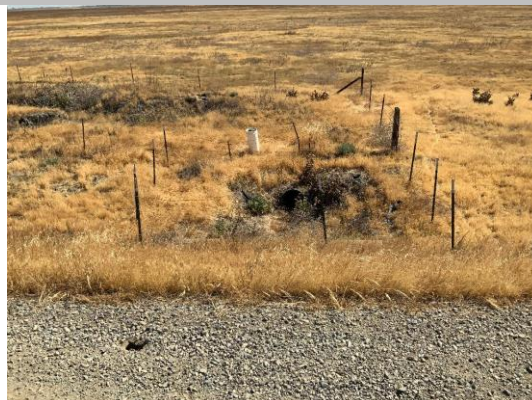
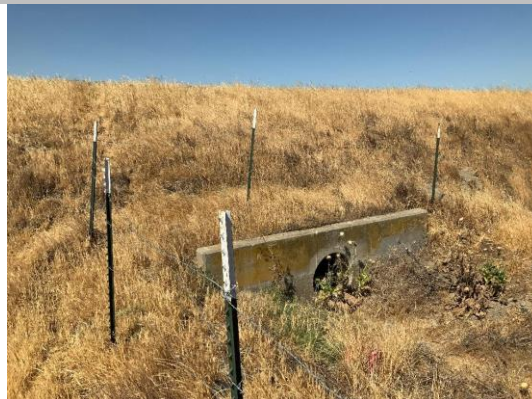
DS\_ID:19899  
FS\_ID:67301  
EP\_NO: N/A  
Repair Type: Non-Urgent  
EVAL Issue: Limited Inspection/No UCIP Evaluation  
Crossing Status: Found  
UCIP Comments: 06/2/2021 The record has been upgraded from No Action Needed to Non-Urgent. LS pipe end surrounded by barbed wire, could not inspect closely. Metal pipe and plastic riser with flowmeter off the LS toe. DWR DMP internal inspection has not found pipe integrity issues. LOF of crossing is less or equal to 4.0. Recommend next video inspection in 5 years. No permit was found authorizing this encroachment. CVFPB will need to review crossing to determine owner. The UCIP inspection was completed with GEI staff, P. Espinoza. (H. Dunn – GEI)  
FIELD\_STRUCT\_DESC: 24-inch corrugated metal gravity drainage pipe through the levee, 9.5 feet below the crown. Flap gate on the waterside (WS) end. Concrete headwall on the landside (LS) end. Concrete U-shaped headwall on the WS end. [Additional Reference(s): DWR Levee Log, 2002 (HLM 2.49), listed as a 24-inch corrugated metal pipe (CMP). USACE San Joaquin O&M Manual, Unit 601 Part 1 (SJR601.1), 1967, (HLM 2.48), listed as a 24-inch CMP].

Levee crown looking downstream.

LS view: Toe from crown.

LS view: Slope and headwall at toe.

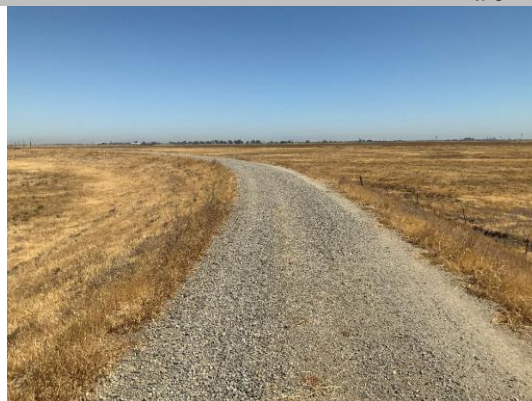
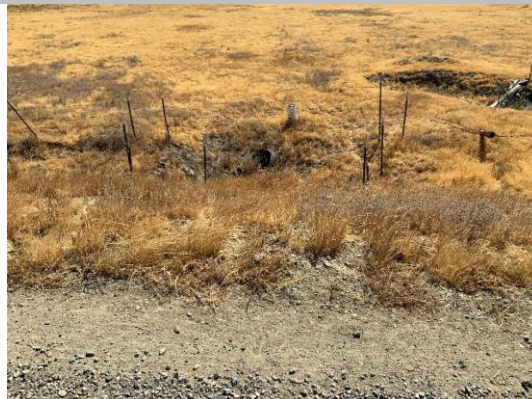
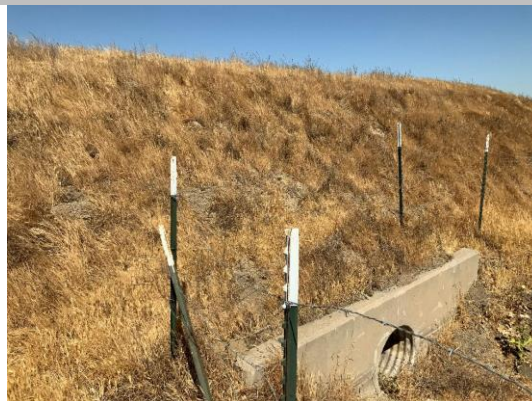
DS\_ID:19900  
 FS\_ID:67302  
 EP\_NO: N/A  
 Repair Type: Non-Urgent  
 EVAL Issue: Limited Inspection/No UCIP Evaluation  
 Crossing Status: Found  
 UCIP Comments: 06/2/2021 The record has been upgraded from No Action Needed to Non-Urgent. LS pipe end surrounded by barbed wire, inspection was limited. No permit was found authorizing this encroachment. CVFPB will need to review crossing to determine owner. The UCIP inspection was completed with GEI staff, P. Espinoza. (H. Dunn – GEI)  
 FIELD\_STRUCT\_DESC: 24-inch corrugated metal gravity drainage pipe through the levee, 11.5 feet below the crown. Flap gate on the waterside (WS) end. Concrete headwall on the landside (LS) end. Concrete U-shaped headwall on the WS end. [Additional Reference(s): DWR Levee Log, 2002 (HLM 2.65), listed as a 24-inch corrugated metal pipe (CMP). USACE San Joaquin O&M Manual, Unit 601 Part 1 (SJR601.1), 1967, (HLM 2.64), listed as a 24-inch CMP].

Levee crown looking downstream.

LS view: Toe from crown.

LS view: Slope and headwall at toe.

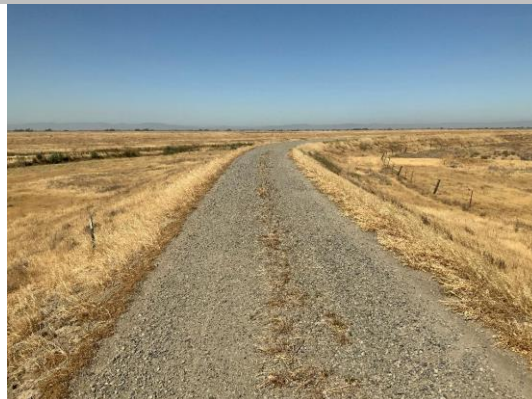
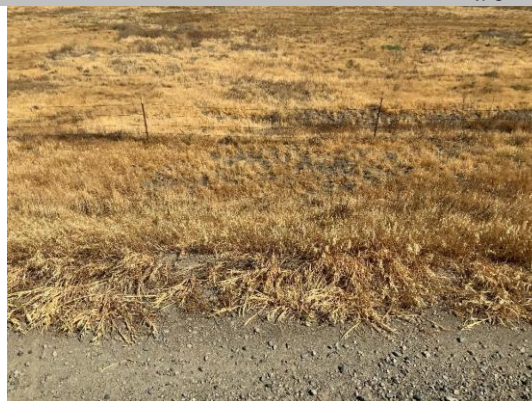
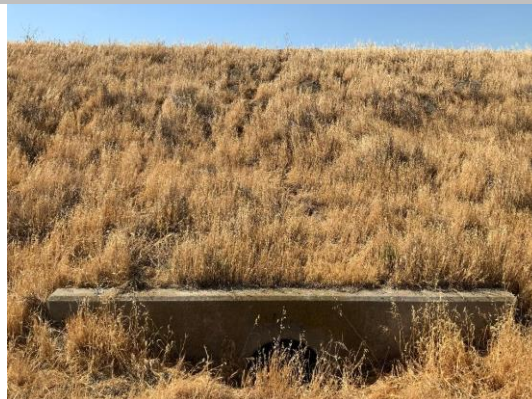
DS\_ID:19901  
FS\_ID:67934  
EP\_NO: N/A  
Repair Type: Non-Urgent  
EVAL Issue: Pipe Damage  
Crossing Status: Found  
UCIP Comments: 06/2/2021 Record remains Non-Urgent. DWR DMP internal inspection has found pipe integrity issues. LOF of crossing is equal to 4.1 and less than 5. Crossing will be monitored until funding becomes available for rehabilitation. Some sediment buildup in the inlet of the pipe on the LS, recommend cleaning out. No permit was found authorizing this encroachment. CVFPB will need to review crossing to determine owner. The UCIP inspection was completed with GEI staff, P. Espinoza. (H. Dunn – GEI) 04/15/2014 Some sediment buildup at landward toe and inside pipe--recommend clearing. (W. Wylie - DWR UCIP)  
FIELD\_STRUCT\_DESC: 24-inch corrugated metal gravity drainage pipe through the levee, 10.4 feet below the crown. Flap gate on the waterside (WS) end. Concrete headwall on the landside (LS) end. Concrete U-shaped headwall on the WS end. [Additional Reference(s): DWR Levee Log, 2002 (HLM 3.09), listed as a 24-inch corrugated metal pipe (CMP). USACE San Joaquin O&M Manual, Unit 601 Part 1 (SJR601.1), 1967, (HLM 3.09), listed as a 24-inch CMP].

Levee crown looking downstream.

LS view: Toe from crown.

LS view: Slope and headwall at toe.

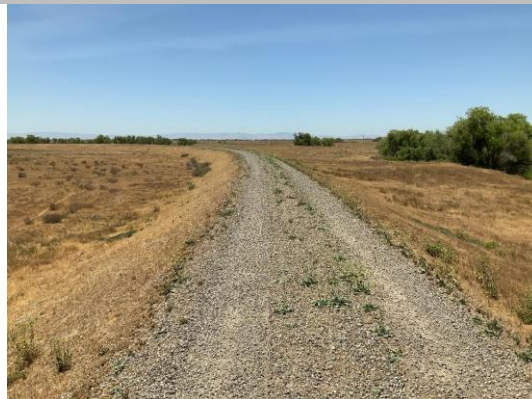
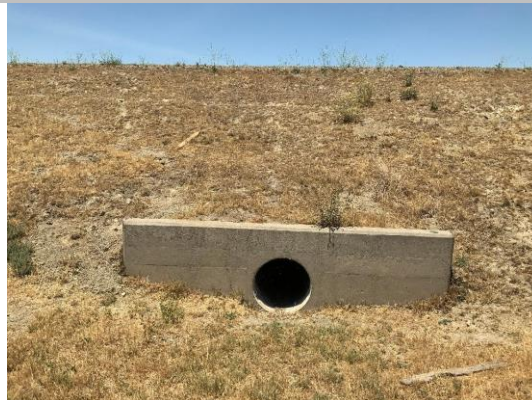
Comment Code					
Inspector Comment					
DS_ID:19903 FS_ID:67309 EP_NO: N/A Repair Type: Non-Urgent EVAL Issue: Unauthorized Encroachment, installed decades prior Crossing Status: Found UCIP Comments: 06/2/2021 The record has been upgraded from No Action Needed to Non-Urgent. DWR DMP internal inspection has not found pipe integrity issues. LOF of crossing is less or equal to 4.0. Recommend next video inspection in 5 years. No permit was found authorizing this encroachment. CVFPB will need to review crossing to determine owner. The UCIP inspection was completed with GEI staff, P. Espinoza. (H. Dunn – GEI) FIELD_STRUCT_DESC: 24-inch corrugated metal gravity drainage pipe through the levee, 9.6 feet below the crown. Flap gate on the waterside (WS) end. Concrete headwall on the landside (LS) end. Concrete U-shaped headwall on the WS end. [Additional Reference(s): DWR Levee Log, 2002 (HLM 0.23), listed as a 24-inch corrugated metal pipe (CMP). USACE San Joaquin O&M Manual, Unit 601 Part 1 (SJR601.1), 1967, (HLM 0.23), listed as a 24-inch CMP]. FS Date: 6/2/2021

Levee crown looking downstream.

LS view: Slope and headwall at toe.

LS view: Close up of pipe inlet at toe.

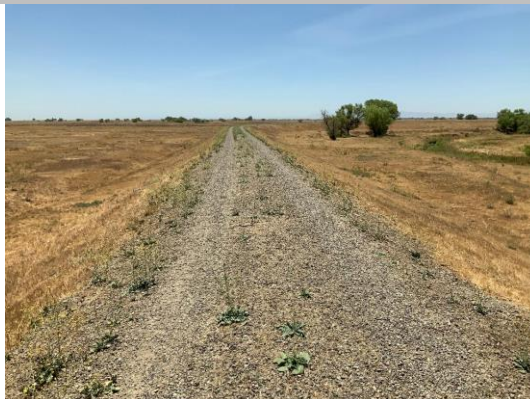
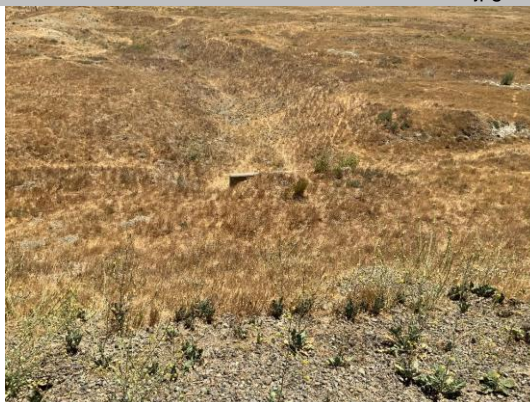
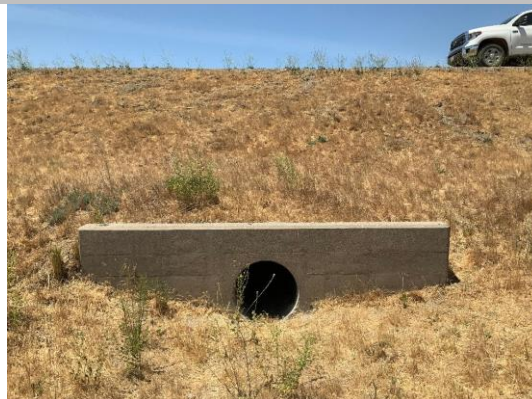
DS\_ID:19904  
FS\_ID:67314  
EP\_NO: N/A  
Repair Type: Non-Urgent  
EVAL Issue: Unauthorized Encroachment, installed decades prior  
Crossing Status: Found  
UCIP Comments: 06/2/2021 The record has been upgraded from No Action Needed to Non-Urgent. DWR DMP internal inspection has not found pipe integrity issues. LOF of crossing is less or equal to 4.0. Recommend next video inspection in 5 years. No permit was found authorizing this encroachment. CVFPB will need to review crossing to determine owner. The UCIP inspection was completed with GEI staff, P. Espinoza. (H. Dunn – GEI)  
FIELD\_STRUCT\_DESC: 24-inch corrugated metal gravity drainage pipe through the levee, 12.4 feet below the crown. Flap gate on the waterside (WS) end. Concrete headwall on each end. [Additional Reference(s): DWR Levee Log, 2002 (HLM 0.55), listed as a 24-inch corrugated metal pipe (CMP). USACE San Joaquin O&M Manual, Unit 601 Part 1 (SJR601.1), 1967, (HLM 0.57), listed as a 24-inch CMP].

Levee crown looking downstream.

LS view: Headwall visible at toe from crown.

LS view: Slope and headwall at toe.

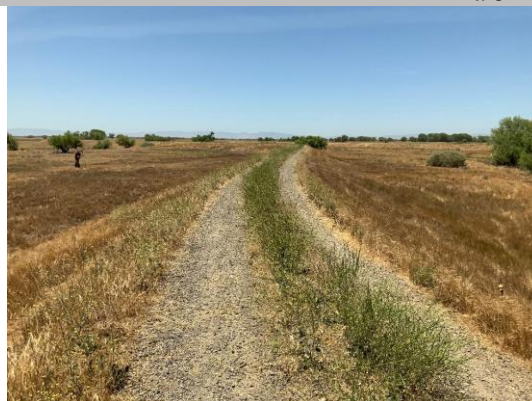
DS\_ID:19905  
 FS\_ID:67311  
 EP\_NO: N/A  
 Repair Type: Non-Urgent  
 EVAL Issue: Unauthorized Encroachment, installed decades prior  
 Crossing Status: Found  
 UCIP Comments: 06/2/2021 The record has been upgraded from No Action Needed to Non-Urgent. DWR DMP internal inspection has not found pipe integrity issues. LOF of crossing is less or equal to 4.0. Recommend next video inspection in 5 years. No permit was found authorizing this encroachment. CVFPB will need to review crossing to determine owner. The UCIP inspection was completed with GEI staff, P. Espinoza. (H. Dunn – GEI)  
 FIELD\_STRUCT\_DESC: 24-inch corrugated metal gravity drainage pipe through the levee, 10 feet below the crown. Flap gate on the waterside (WS) end. Concrete headwall on each end. [Additional Reference(s): DWR Levee Log, 2002 (HLM 0.70), listed as a 24-inch corrugated metal pipe (CMP). USACE San Joaquin O&M Manual, Unit 601 Part 1 (SJR601.1), 1967, (HLM 0.72), listed as a 24-inch CMP].

Levee crown looking downstream.

LS view: Toe from crown.

LS view: Slope and headwall at toe.

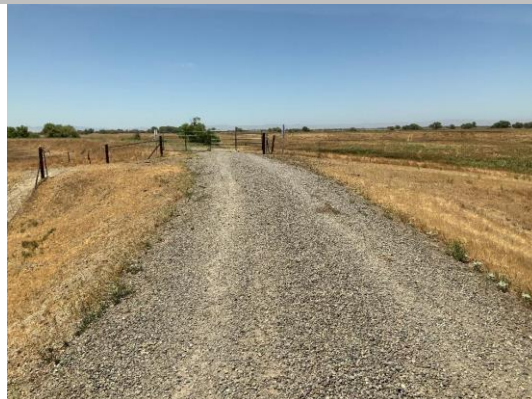
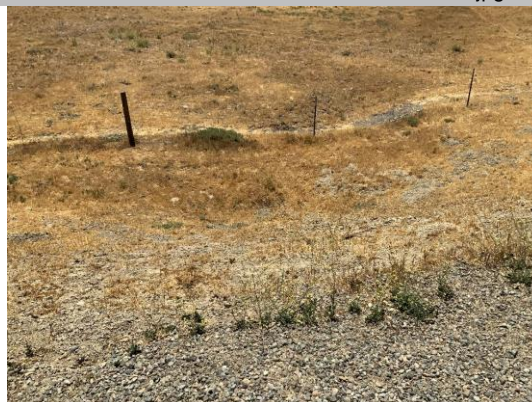
DS\_ID:19832  
FS\_ID:67312  
EP\_NO: N/A  
Repair Type: Non-Urgent  
EVAL Issue: Unauthorized Encroachment, installed decades prior  
Crossing Status: Found  
UCIP Comments: 06/2/2021 Record remains Non-Urgent. DWR DMP internal inspection has not found pipe integrity issues. LOF of crossing is less or equal to 4.0. Recommend next video inspection in 5 years. No permit was found authorizing this encroachment. CVFPB will need to review crossing to determine owner. The UCIP inspection was completed with GEI staff, P. Espinoza. (H. Dunn – GEI) 04/16/2014  
Some sediment buildup at inlet on LS toe. (W. Wylie - DWR UCIP)  
FIELD\_STRUCT\_DESC: 24-inch corrugated metal gravity drainage pipe through the levee, 11.5 feet below the crown. Flap gate on the waterside (WS) end. Concrete headwall on each end. [Additional Reference(s): DWR Levee Log, 2002 (HLM 0.88), listed as a 24-inch corrugated metal pipe (CMP). USACE San Joaquin O&M Manual, Unit 601 Part 1 (SJR601.1), 1967, (HLM 0.89), listed as a 24-inch CMP].

Levee crown looking downstream.

LS view: Toe from crown.

LS view: Slope and headwall at toe.

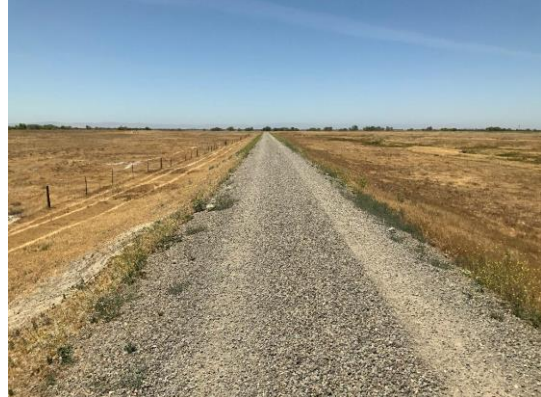
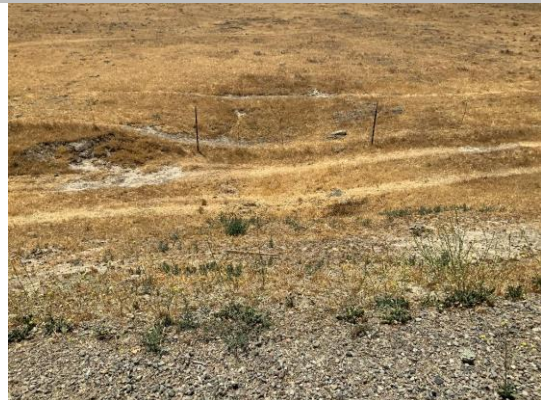
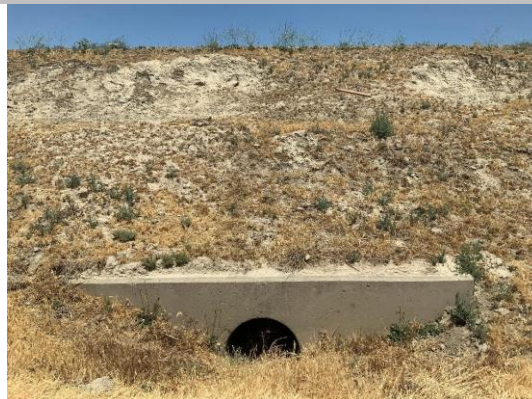
Comment Code						
Inspector Comment						
DS_ID:19833 FS_ID:67313 EP_NO: N/A Repair Type: Non-Urgent EVAL Issue: Maintenance Compliance Issue Crossing Status: Found UCIP Comments: 06/2/2021 Record remains Non-Urgent. Some vegetation in LS pipe inlet, recommend clearing out. DWR DMP internal inspection has not found pipe integrity issues. LOF of crossing is less or equal to 4.0. Recommend next video inspection in 5 years. No permit was found authorizing this encroachment. CVFPB will need to review crossing to determine owner. The UCIP inspection was completed with GEI staff, P. Espinoza. (H. Dunn – GEI) 04/16/2014 Debris blocking landward headwall--recommend clearing. (W. Wylie - DWR UCIP) FIELD_STRUCT_DESC: 24-inch corrugated metal gravity drainage pipe through the levee, 11.6 feet below the crown. Flap gate on the waterside (WS) end. Concrete headwall on each end. [Additional Reference(s): DWR Levee Log, 2002 (HLM 1.20), listed as a 24-inch corrugated metal pipe (CMP). USACE San Joaquin O&M Manual, Unit 601 Part 1 (SJR601.1), 1967, (HLM 1.21), listed as a 24-inch CMP]. FS Date: 6/2/2021

Levee crown looking downstream.

LS view: Toe from crown.

LS view: Slope and headwall at toe.

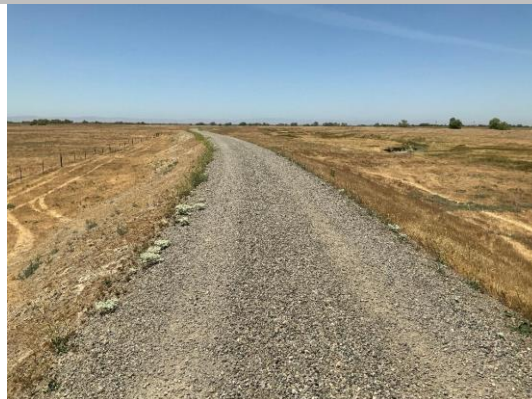
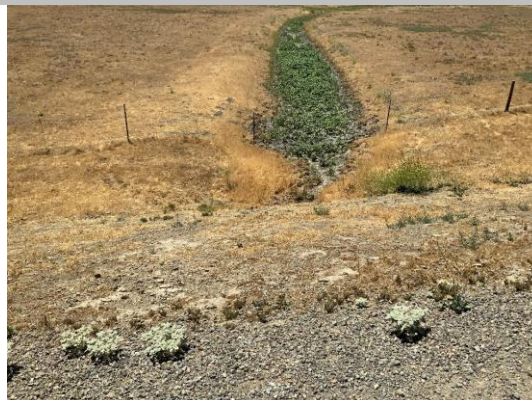
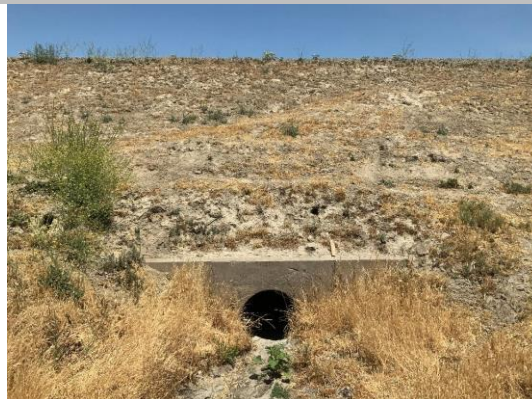
DS\_ID:19834  
FS\_ID:67315  
EP\_NO: N/A  
Repair Type: Non-Urgent  
EVAL Issue: Maintenance Compliance Issue  
Crossing Status: Found  
UCIP Comments: 06/2/2021 Record remains Non-Urgent. Vegetation sticking out of WS flapgate, recommend removal. DWR DMP internal inspection has not found pipe integrity issues. LOF of crossing is less or equal to 4.0. Recommend next video inspection in 5 years. No permit was found authorizing this encroachment. CVFPB will need to review crossing to determine owner. The UCIP inspection was completed with GEI staff, P. Espinoza. (H. Dunn – GEI) 04/16/2014 Animal burrows along pipe alignment on LS. Some sediment buildup at LS toe and inside pipe--recommend clearing. (W. Wylie -DWR UCIP)  
FIELD\_STRUCT\_DESC: 24-inch corrugated metal gravity drainage pipe through the levee, 11.5 feet below the crown. Flap gate on the waterside (WS) end. Concrete headwall on each end. [Additional Reference(s): DWR Levee Log, 2002 (HLM 1.37), listed as a 24-inch corrugated metal pipe (CMP). USACE San Joaquin O&M Manual, Unit 601 Part 1 (SJR601.1), 1967, (HLM 1.38), listed as a 24-inch CMP].

Levee crown looking downstream.

LS view: Toe from crown.

LS view: Slope and headwall at toe.

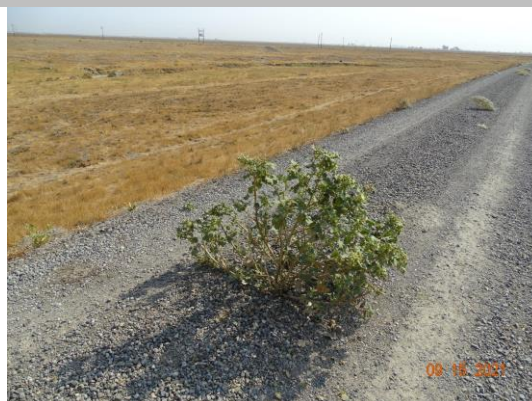
Photo 1 of 1 : FA\_2021\_NA0010\_126\_23\_20211005\_00043.jpg

LM Start	1.76	Rating **	M	Issue No.	23
LM End	1.76	Issue Type +	Ma	Location *	CR
Category	Earthen Levee			GPS Latitude/Longitude	
				Start	End
Item	Vegetation			37.260888 °	37.260888 °
				-120.746053 °	-120.746053 °
DWR ID	DWR_NA0010_08_f_2021_23				
Comment Code					
V2 : Remove the wild growth other than native grasses from the levee slopes.					
Inspector Comment					
Bush growing in levee crown needs to be removed.

View of bush growing in the levee crown. (Fall 2021)
