## Flood Control Project Maintenance Levee Inspections

### Fall 2021 Levee Maintenance Deficiency Summary Report

#### San Joaquin River Basin

NA0010 Lower San Joaquin Levee District	Overall LMA Rating	Total LMA Miles							
	U	191.27							
Rated Item	Maintenance Deficiency				Enforcement		Design & System Obsolescence		
	M Miles	U Miles	M + 4U Miles	Threshold %	M Miles	U Miles	M Miles	U Miles	
<i>Earthen Levee</i>									
Vegetation	47.00	9.57	85.28	44.59%					
Trim / Thin Trees	0.10		0.10	0.05%					
Encroachments	0.23	0.02	0.31	0.16%	9.29	0.59			
Animal Control	7.67	2.19	16.43	8.59%					
Slope Stability	0.05	0.01	0.09	0.05%					
Erosion / Bank Caving	0.13	0.81	3.37	1.76%					
Crown Surface / Depressions / Rutting	0.01		0.01	0.01%					
Repair Gates	0.02	0.02	0.10	0.05%					
<i>Rivers, Channels &amp; Designated Floodways</i>									
Encroachments					0.01	0.01			
<i>Supplemental</i>									
DWR Erosion Survey	0.12	0.17	0.80	0.42%					
DWR UCIP Field Study					1.29	0.05			
DWR UCIP LMA Responsibility									
<i>LMA Totals:</i>	55.33	12.79	106.49	55.67%	10.59	0.65	0.00	0.00

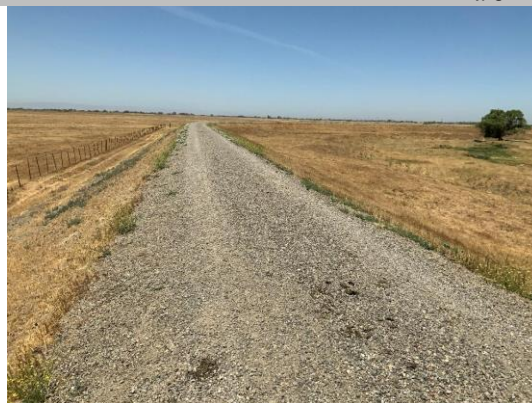
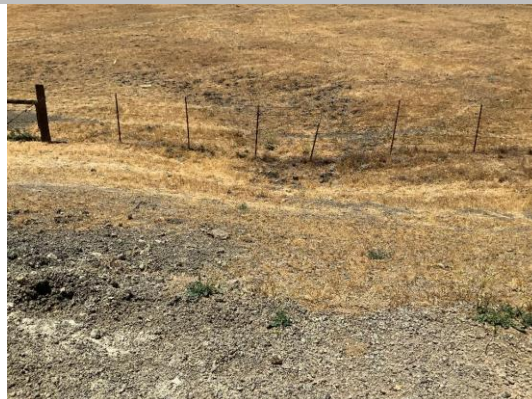
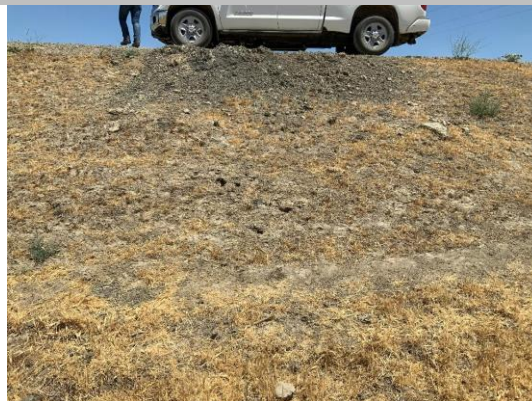
Comment Code						
Inspector Comment						
DS_ID:19835 FS_ID:67316 EP_NO: N/A Repair Type: Non-Urgent EVAL Issue: Unauthorized Encroachment, installed decades prior Crossing Status: Found UCIP Comments: 06/2/2021 Record remains Non-Urgent. LS pipe end not visible at all, appears to be buried or removed. Need to contact owner to determine status of pipe. DWR DMP internal inspection has not found pipe integrity issues. LOF of crossing is less or equal to 4.0. Recommend next video inspection in 5 years. No permit was found authorizing this encroachment. CVFPB will need to review crossing to determine owner. The UCIP inspection was completed with GEI staff, P. Espinoza. (H. Dunn – GEI) 04/16/2014 Non-functional landward inlet is buried in sediment. Need to contact owner to determine status. (W. Wylie - DWR UCIP) FIELD_STRUCT_DESC: 24-inch corrugated metal gravity drainage pipe through the levee, 12 feet below the crown. Flap gate on the waterside (WS) end. Concrete headwall on each end. [Additional Reference(s): DWR Levee Log, 2002 (HLM 2.04), listed as a 24-inch corrugated metal pipe (CMP). USACE San Joaquin O&M Manual, Unit 601 Part 1 (SJR601.1), 1967, (HLM 2.05), listed as a 24-inch CMP]. FS Date: 6/2/2021

Levee crown looking downstream.

LS view: Toe from crown, no pipe visible.

LS view: Slope from toe, no pipe visible.

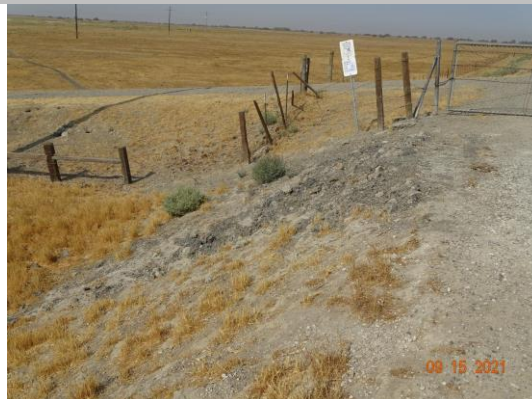
Photo 1 of 1 : FA\_2021\_NA0010\_126\_22\_20211005\_00045.jpg

LM Start	2.07	Rating **	A/W	Issue No.	22
LM End	2.07	Issue Type +	Ma	Location *	LS
Category	Earthen Levee			GPS Latitude/Longitude	
				Start	End
Item	Animal Control			37.258076 °	37.258076 °
				-120.742439 °	-120.742439 °
DWR ID	DWR_NA0010_08_f_2018_22				
Comment Code					
A2 : Repair the levee slope damaged by livestock and prevent large animal access.					
Inspector Comment					
Erosion from livestock has been repaired. Monitor for settlement.

Repaired slope damage should be monitored for settlement. (Fall 2021)

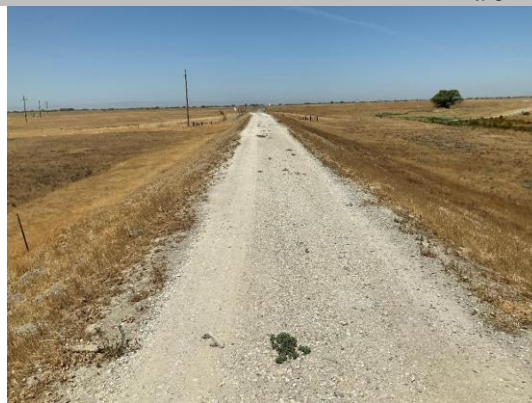
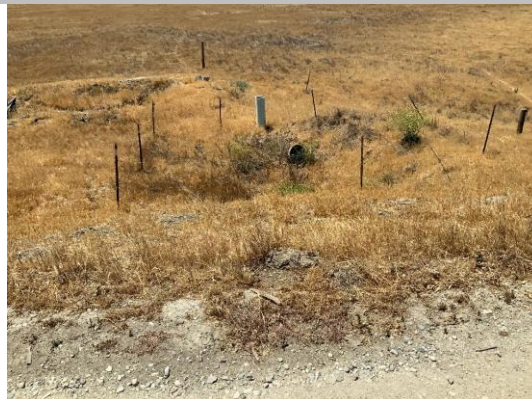
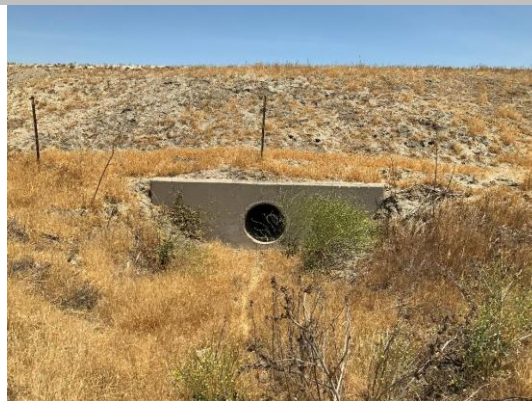
Comment Code						
Inspector Comment						
DS_ID:19836 FS_ID:67935 EP_NO: N/A Repair Type: Non-Urgent EVAL Issue: Unauthorized Encroachment, installed decades prior Crossing Status: Found UCIP Comments: 06/2/2021 The record remains Non-Urgent. DWR DMP internal inspection has not found pipe integrity issues. LOF of crossing is less or equal to 4.0. Recommend next video inspection in 5 years. New 6 inch plastic riser with flowmeter and 24 inch metal pipe underground off the LS toe, directly opposite of the LS pipe inlet of this DSID. No permit was found authorizing this encroachment. CVFPB will need to review crossing to determine owner. The UCIP inspection was completed with GEI staff, P. Espinoza. (H. Dunn – GEI) 04/16/2014 Sediment buildup in pipe visible from landward side. (W. Wylie - DWR UCIP) FIELD_STRUCT_DESC: 24-inch corrugated metal gravity drainage pipe through the levee, 9.5 feet below the crown. Flap gate on the waterside (WS) end. Concrete headwall on each end. [Additional Reference(s): DWR Levee Log, 2002 (HLM 2.12), listed as a 24-inch corrugated metal pipe (CMP). USACE San Joaquin O&M Manual, Unit 601 Part 1 (SJR601.1), 1967, (HLM 2.12), listed as a 24-inch CMP]. FS Date: 6/2/2021

Levee crown looking downstream.

LS view: Toe from crown.

LS view: Slope and headwall at toe.

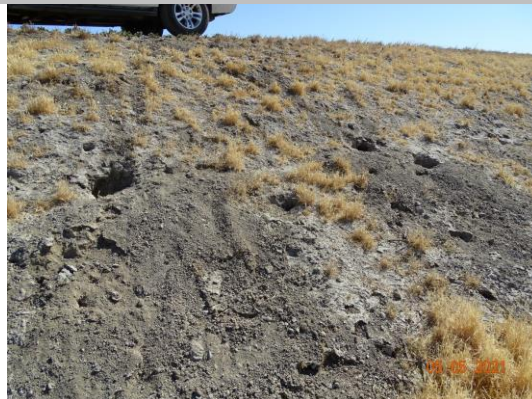
Photo 1 of 1 : FA\_2021\_NA0010\_126\_18\_20210830\_00002.jpg

LM Start	2.29	Rating **	M	Issue No.	18
LM End	2.43	Issue Type +	Ma	Location *	LS
Category	Earthen Levee			GPS Latitude/Longitude	
				Start	End
Item	Animal Control			37.256251 °	37.254767 °
				-120.739280 °	-120.737772 °
DWR ID	DWR_NA0010_08_s_2021_18				
Comment Code					
A1 : Exterminate rodents and backfill and compact or grout burrows.					
Inspector Comment

View of rodent holes in the landside slope. (Spring 2021)

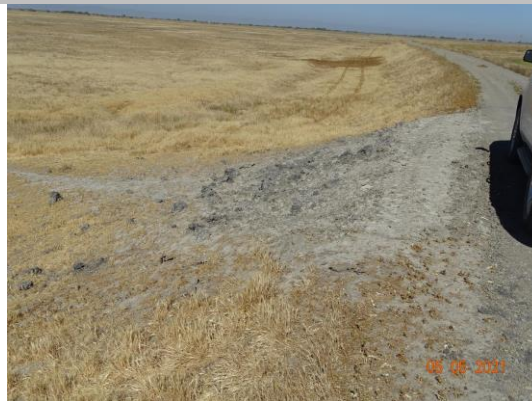
Photo 1 of 1 : FA\_2021\_NA0010\_126\_20\_20210830\_00004.jpg

LM Start	2.74	Rating **	A/W	Issue No.	20
LM End	2.74	Issue Type +	Ma	Location *	LS
Category	Earthen Levee			GPS Latitude/Longitude	
				Start	End
Item	Animal Control			37.252503 °	37.252503 °
				-120.733282 °	-120.733282 °
DWR ID	DWR_NA0010_08_f _ 2018_20				
Comment Code					
A2 : Repair the levee slope damaged by livestock and prevent large animal access.					
Inspector Comment					
Erosion from livestock has been repaired. Monitor for settlement.

View of repaired slope damage. (Spring 2021)

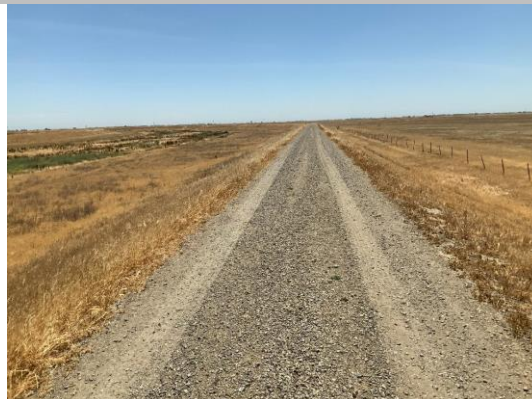
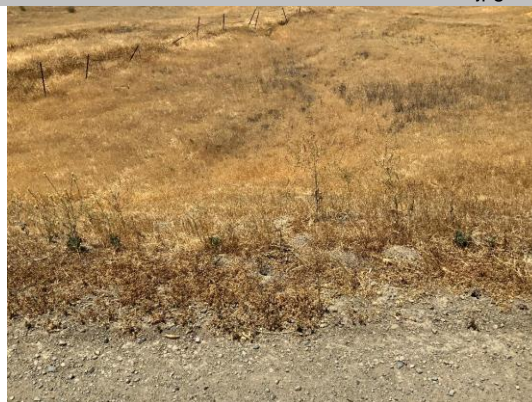
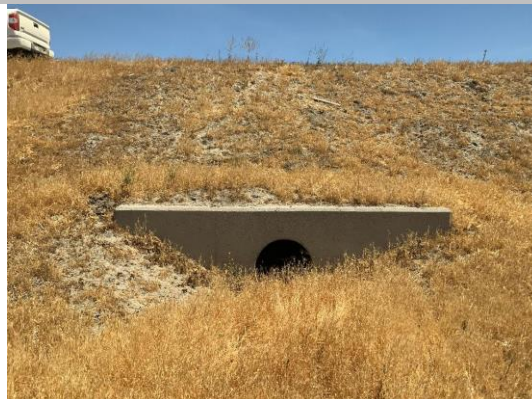
DS\_ID:19837  
FS\_ID:67318  
EP\_NO: N/A  
Repair Type: Non-Urgent  
EVAL Issue: Unauthorized Encroachment, installed decades prior  
Crossing Status: Found  
UCIP Comments: 06/2/2021 The record has been upgraded from No Action Needed to Non-Urgent. DWR DMP internal inspection has not found pipe integrity issues. LOF of crossing is less or equal to 4.0. Recommend next video inspection in 5 years. No permit was found authorizing this encroachment. CVFPB will need to review crossing to determine owner. The UCIP inspection was completed with GEI staff, P. Espinoza. (H. Dunn – GEI)  
FIELD\_STRUCT\_DESC: 24-inch corrugated metal gravity drainage pipe through the levee, 10.5 feet below the crown. Flap gate on the waterside (WS) end. Concrete headwall on each end. [Additional Reference(s): DWR Levee Log, 2002 (HLM 2.77), listed as a 24-inch corrugated metal pipe (CMP). USACE San Joaquin O&M Manual, Unit 601 Part 1 (SJR601.1), 1967, (HLM 2.77), listed as a 24-inch CMP].

Levee crown looking downstream.

LS view: Toe from crown.

LS view: Slope and headwall at toe.

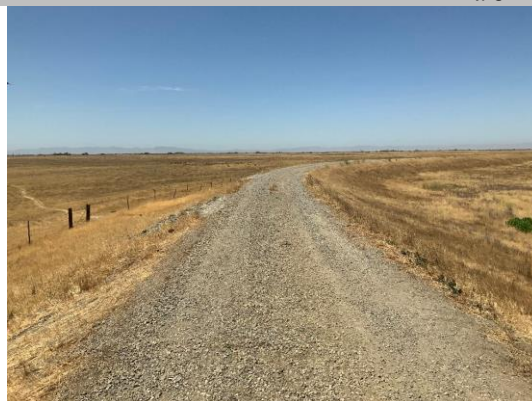
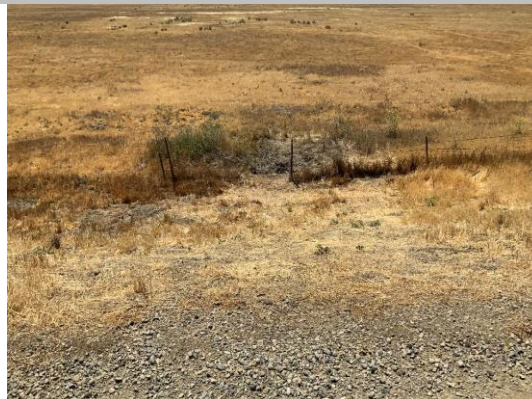
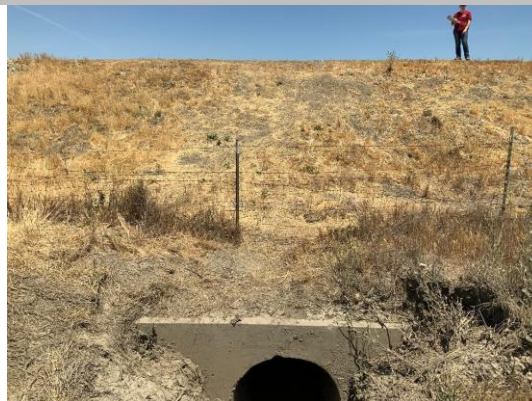
DS\_ID:19838  
FS\_ID:67320  
EP\_NO: N/A  
Repair Type: Non-Urgent  
EVAL Issue: Maintenance Compliance Issue  
Crossing Status: Found  
UCIP Comments: 06/2/2021 Record remains Non-Urgent. LS pipe inlet has some sediment buildup, recommend cleaning out. No permit was found authorizing this encroachment. CVFPB will need to review crossing to determine owner. The UCIP inspection was completed with GEI staff, P. Espinoza. (H. Dunn – GEI) 7/20/2016 LS inlet buried under dense vegetation. Dense vegetation limits the inspector's visibility to identify signs of pipe failure (leaks) along the WS and LS slope. Recommend removing vegetation along pipe alignment to conduct proper inspection of structure and appurtenances. (O. Magana - DWR UCIP)4/16/2014 Pipe blocked by silt on LS toe. Flapgate rusty and does not operate correctly. (W. Wylie - DWR UCIP)  
FIELD\_STRUCT\_DESC: 36-inch corrugated metal gravity drainage pipe through the levee, 13.4 feet below the crown. Flap gate on the waterside (WS) end. Concrete headwall on each end. [Additional Reference(s): DWR Levee Log, 2002 (HLM 3.06), listed as a 36-inch corrugated metal pipe (CMP). USACE San Joaquin O&M Manual, Unit 601 Part 1 (SJR601.1), 1967, (HLM 3.06), listed as a 36-inch CMP].

Levee crown looking downstream.

LS view: Toe from crown.

LS view: Slope and headwall at toe.

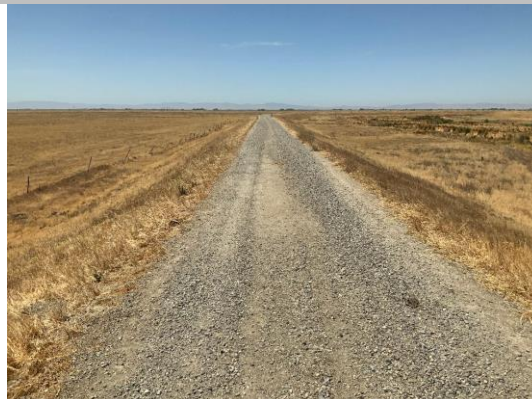
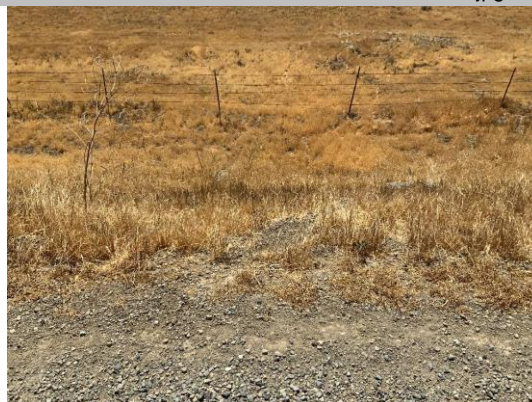
DS\_ID:19839  
FS\_ID:67321  
EP\_NO: N/A  
Repair Type: Non-Urgent  
EVAL Issue: Unauthorized Encroachment, installed decades prior  
Crossing Status: Found  
UCIP Comments: 06/2/2021 The record has been upgraded from No Action Needed to Non-Urgent. DWR DMP internal inspection has not found pipe integrity issues. LOF of crossing is less or equal to 4.0. Recommend next video inspection in 5 years. No permit was found authorizing this encroachment. CVFPB will need to review crossing to determine owner. The UCIP inspection was completed with GEI staff, P. Espinoza. (H. Dunn – GEI)  
FIELD\_STRUCT\_DESC: 24-inch corrugated metal gravity drainage pipe through the levee, 10 feet below the crown. Flap gate on the waterside (WS) end. Concrete headwall on each end. [Additional Reference(s): DWR Levee Log, 2002 (HLM 3.23), listed as a 24-inch corrugated metal pipe (CMP). USACE San Joaquin O&M Manual, Unit 601 Part 1 (SJR601.1), 1967, (HLM 3.24), listed as a 24-inch CMP].

Levee crown looking downstream

LS view: Toe from crown.

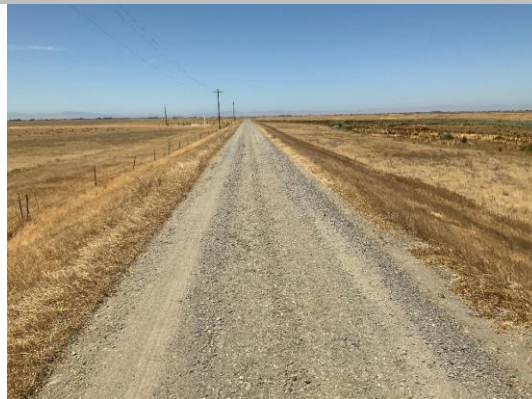
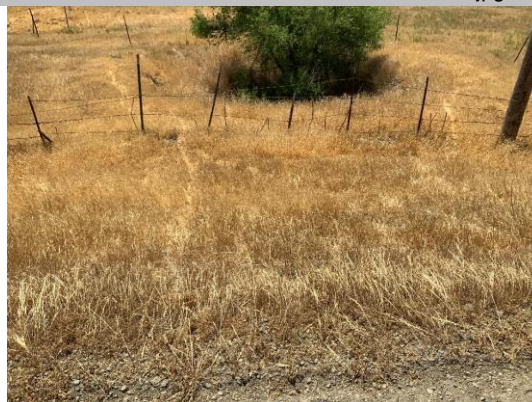
DS\_ID:19840  
FS\_ID:67322  
EP\_NO: N/A  
Repair Type: Non-Urgent  
EVAL Issue: Limited Inspection/No UCIP Evaluation  
Crossing Status: Found  
UCIP Comments: 06/2/2021 Record remains Non-Urgent. LS pipe inlet blocked by barbed wire and both ends blocked by water, so limited inspection was done. No permit was found authorizing this encroachment. CVFPB will need to review crossing to determine owner. The UCIP inspection was completed with GEI staff, P. Espinoza. (H. Dunn – GEI) 04/16/2014 No access available on landward side. Need to confirm status of crossing. (W. Wylie - DWR UCIP)  
FIELD\_STRUCT\_DESC: 24-inch corrugated metal gravity drainage pipe through the levee, 13 feet below the crown. Flap gate on the waterside (WS) end. Concrete headwall on each end. [Additional Reference(s): DWR Levee Log, 2002 (HLM 3.43), listed as a 24-inch corrugated metal pipe (CMP). USACE San Joaquin O&M Manual, Unit 601 Part 1 (SJR601.1), 1967, (HLM 3.43), listed as a 24-inch CMP].

Levee crown looking downstream.

LS view: Toe from crown.

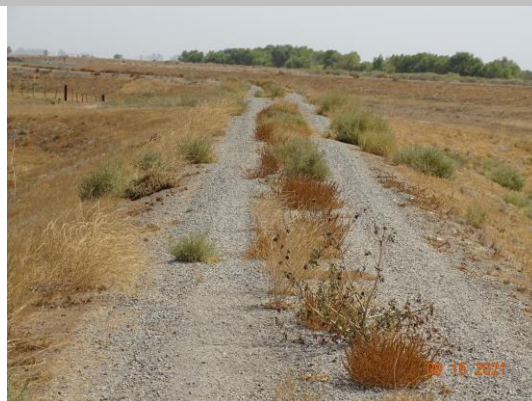
Photo 1 of 1 : FA\_2021\_NA0010\_127\_5\_20211005\_00012.jpg

LM Start	0.25	Rating **	M	Issue No.	5
LM End	0.39	Issue Type +	Ma	Location *	CR
Category	Earthen Levee			GPS Latitude/Longitude	
				Start	End
Item	Vegetation			37.220037 °	37.219916 °
				-120.709133 °	-120.706638 °
DWR ID	DWR_NA0010_09_f _ 2021_5				
Comment Code					
V9 : Keep the crown roadway free of vegetation.					
Inspector Comment

View of vegetation growing along the levee crown. (Fall 2021)

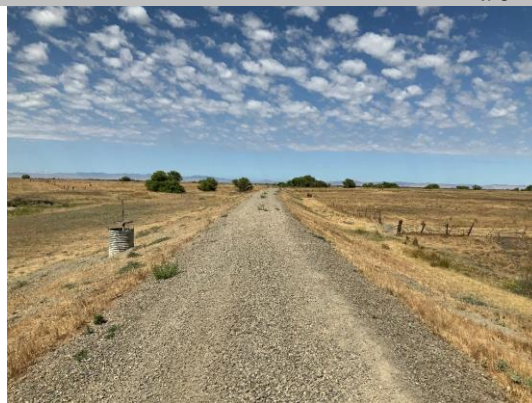
Photo 1 of 3 : UCIP\_FA\_2021\_69554\_103170.jpg

Comment Code						
Inspector Comment						
DS_ID:19841 FS_ID:69554 EP_NO: N/A Repair Type: Non-Urgent EVAL Issue: Safety Issue Crossing Status: Found UCIP Comments: 06/09/2021 The record remains Non-Urgent. Limited inspection of landside (LS) and WS due to water and mud. LS CMP riser has missing lid. WS outlet pipe edges are warped. No permit was found authorizing this encroachment. CVFPB will need to review crossing to determine owner. The UCIP inspection was completed with GEI staff, H.Dunn. (P.Espinoza – GEI) 04/22/2014 Concrete headwalls on landward and waterward under water. Need photo to confirm condition of concrete headwalls, pipe, and gate on both toes. (W. Wylie - DWR UCIP) FIELD_STRUCT_DESC: 24-inch corrugated metal gravity drainage pipe through the levee, 18.7 feet below the crown. Slide gate in a 36-inch corrugated metal pipe (CMP) riser on the waterside (WS) slope. Concrete U-shaped headwall on each end. [Additional Reference(s): DWR Levee Log, 2002 (HLM 0.48), listed as a 24-inch corrugated metal pipe (CMP). USACE San Joaquin O&M Manual, Unit 601 Part 1 (SJR601.1), 1967, (HLM 0.47), listed as a 24-inch CMP]. FS Date: 6/9/2021 2:41:00 PM

Overview of levee from crown facing upstream. CMP riser visible on WS slope.

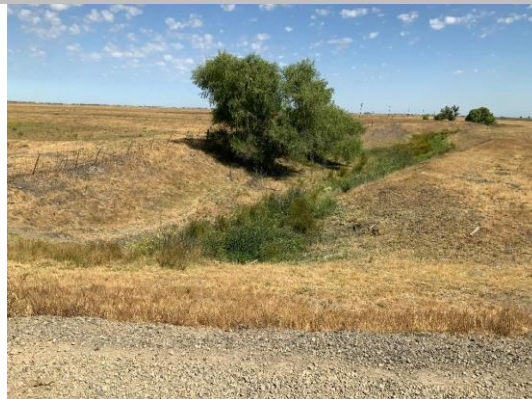
Photo 2 of 3 : UCIP\_FA\_2021\_69554\_103177.jpg

LS view: Toe from crown.

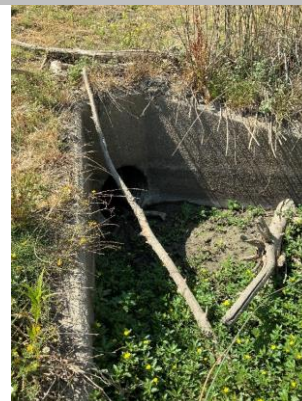
Photo 3 of 3 : UCIP\_FA\_2021\_69554\_103178.jpg

LS view: Concrete headwall and inlet pipe visible at toe.

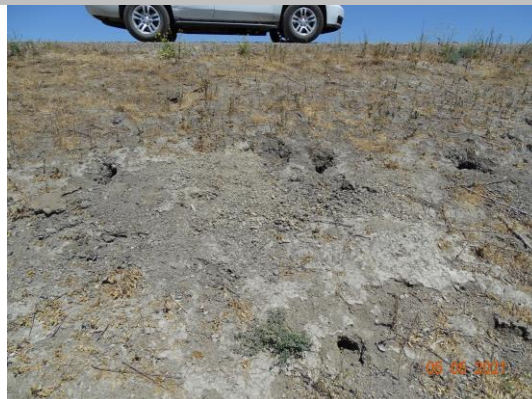
Photo 1 of 1 : FA\_2021\_NA0010\_127\_6\_20210830\_00002.jpg

LM Start	0.48	Rating **	M	Issue No.	6
LM End	0.48	Issue Type +	Ma	Location *	WS
Category	Earthen Levee			GPS Latitude/Longitude	
				Start	End
Item	Animal Control			37.220489 °	37.220489 °
				-120.705021 °	-120.705021 °
DWR ID	DWR_NA0010_09_s_2021_6				
Comment Code					
A1 : Exterminate rodents and backfill and compact or grout burrows.					
Inspector Comment

View of rodent burrows in the waterside slope. (Spring 2021)

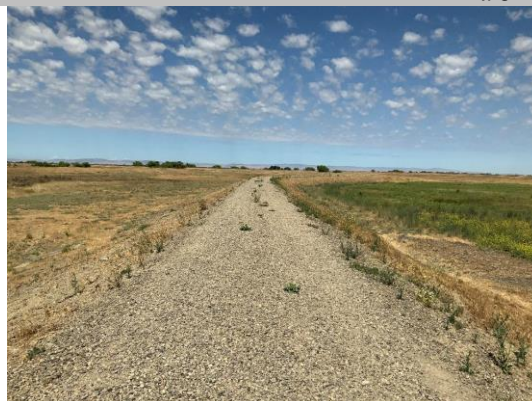
Photo 1 of 3 : UCIP\_FA\_2021\_68984\_103232.jpg

DS\_ID:19842  
FS\_ID:68984  
EP\_NO: N/A  
Repair Type: Non-Urgent  
EVAL Issue: Unauthorized Encroachment, installed decades prior  
Crossing Status: Found  
UCIP Comments: 06/09/2021 The record remains Non-Urgent. DWR DMP internal inspection has not found pipe integrity issues. LOF of crossing is less or equal to 4.0. Recommend next video inspection in 5 years. No permit was found authorizing this encroachment. CVFPB will need to review crossing to determine owner. The UCIP inspection was completed with GEI staff, H.Dunn. (P.Espinoza – GEI) 04/22/2014  
Animal burrows in area on LS slope. Minor sediment buildup in pipe visible on landward side--recommend clearing. (W. Wylie - DWR UCIP)  
FIELD\_STRUCT\_DESC: 24-inch corrugated metal gravity drainage pipe through the levee, 8.7 feet below the crown. Flap gate on the waterside (WS) end. Concrete headwall on the landside (LS) end. Concrete U-shaped headwall on the WS end. [Additional Reference(s): DWR Levee Log, 2002 (HLM 0.70), listed as a 24-inch corrugated metal pipe (CMP). USACE San Joaquin O&M Manual, Unit 601 Part 1 (SJR601.1), 1967, (HLM 0.70), listed as a 24-inch CMP].

View of levee crown.

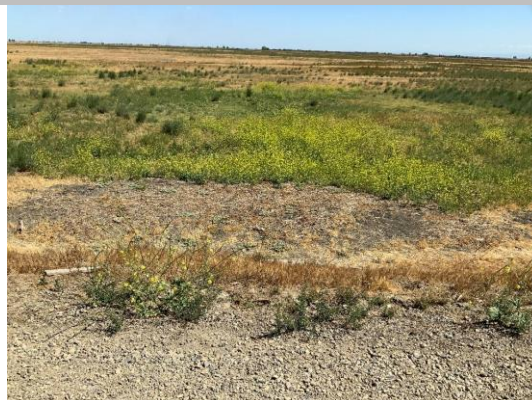
Photo 2 of 3 : UCIP\_FA\_2021\_68984\_103233.jpg

LS view: Slope from crown.

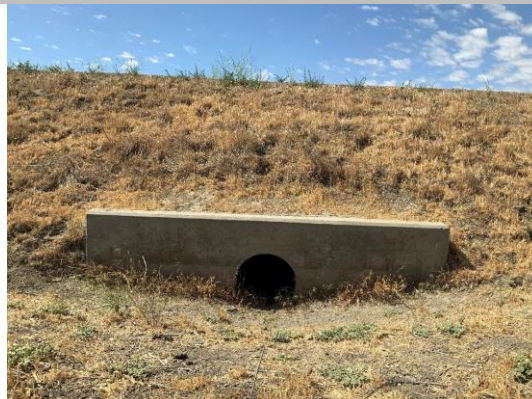
Photo 3 of 3 : UCIP\_FA\_2021\_68984\_103235.jpg

LS view: Concrete headwall and inlet pipe at toe.

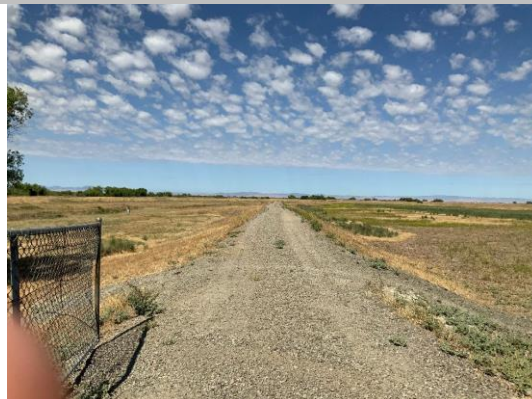
Photo 1 of 3 : UCIP\_FA\_2021\_68989\_103181.jpg

DS\_ID:19843  
FS\_ID:68989  
EP\_NO: N/A  
Repair Type: Non-Urgent  
EVAL Issue: Safety Issue  
Crossing Status: Found  
UCIP Comments: 06/09/2021 The record has been upgraded from No Action Needed to Non-Urgent. No cover or handle on CMP riser on WS slope. Water in riser shows evidence that flapgate is open. Outlet pipe on WS toe not found. Dense vegetation and sediment limits inspectors ability to identify signs of inlet pipe condition on LS toe recommend removal of vegetation and sediment. LS inlet pipe appears to have slight warping around edges. No permit was found authorizing this encroachment. CVFPB will need to review crossing to determine owner. The UCIP inspection was completed with GEI staff, H.Dunn. (P.Espinoza – GEI)  
FIELD\_STRUCT\_DESC: [Crane Irrigation Structure] 24-inch corrugated metal gravity drainage pipe through the levee, 9.7 feet below the crown. Two slide gates in a 48-inch corrugated metal pipe (CMP) riser on the waterside (WS) slope. Concrete U-shaped headwall on the landside (LS) end. WS end cobble revetted on the bank and in the outlet drain. [Additional Reference(s): DWR Levee Log, 2002 (HLM 0.87), listed as a 24-inch corrugated metal pipe (CMP). USACE San Joaquin O&M Manual, Unit 601 Part 1 (SJR601.1), 1967, (HLM 0.87), listed as a 24-inch CMP].

View of levee crown.

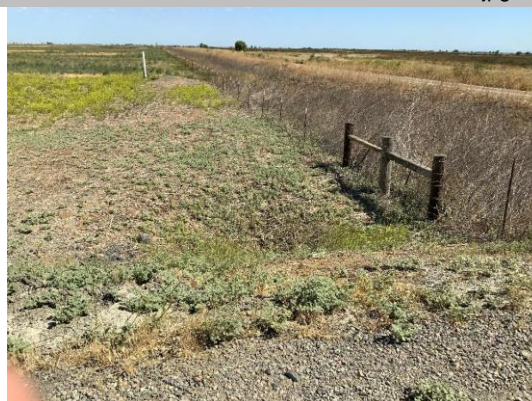
Photo 2 of 3 : UCIP\_FA\_2021\_68989\_103183.jpg

LS view: Toe from crown.

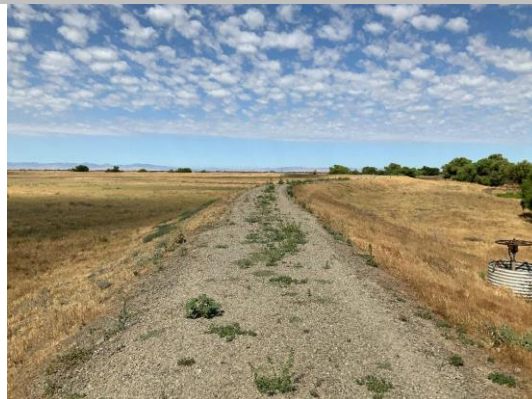
Photo 1 of 3 : UCIP\_FA\_2021\_69817\_103399.jpg

Comment Code						
Inspector Comment						
DS_ID:19845 FS_ID:69817 EP_NO: N/A Repair Type: Non-Urgent EVAL Issue: Safety Issue Crossing Status: Found UCIP Comments: 06/09/2021 The record remains Non-Urgent. No cover on CMP riser on WS slope, creating a safety hazard. Limited inspection of inlet pipe on LS and outlet pipe on WS due to elevated water levels around the headwalls and inlet/outlets, limiting the ability to inspect pipes at a close proximity. No permit was found authorizing this encroachment. CVFPB will need to review crossing to determine owner. The UCIP inspection was completed with GEI staff, H.Dunn. (P.Espinoza – GEI) 04/22/2014 Inlet blocked at LS toe by wooden gate. Need to contact owner to determine status. (W. Wylie - DWR UCIP) FIELD_STRUCT_DESC: 36-inch corrugated metal gravity drainage pipe through the levee, 19.6 feet below the crown. Slide gate in a 48-inch corrugated metal pipe (CMP) riser on the waterside (WS) slope. Concrete U-shaped headwall on each end. [Additional Reference(s): DWR Levee Log, 2002 (HLM 0.31), listed as a 24-inch corrugated metal pipe (CMP). USACE San Joaquin O&M Manual, Unit 601 Part 1 (SJR601.1), 1967, (HLM 0.31), listed as a 24-inch CMP]. FS Date: 6/9/2021 11:34:00 AM

View of levee crown.

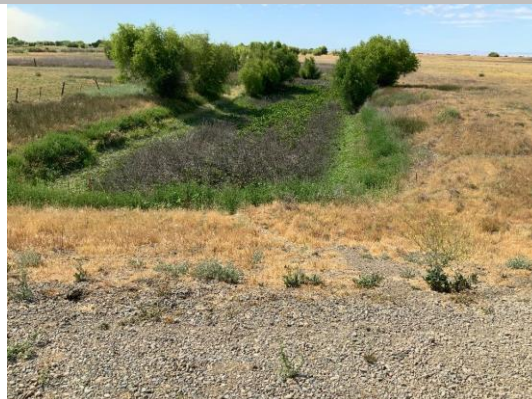
Photo 2 of 3 : UCIP\_FA\_2021\_69817\_103400.jpg

LS view: Toe from crown.

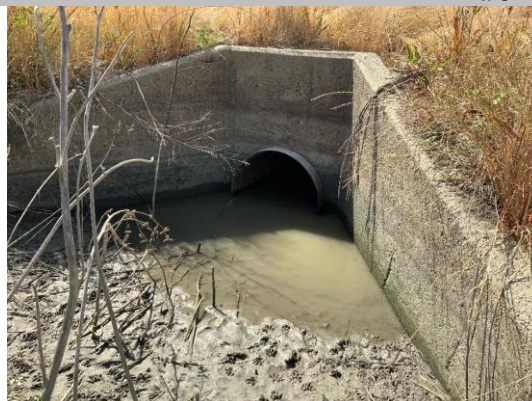
Photo 3 of 3 : UCIP\_FA\_2021\_69817\_103403.jpg

WS view: Concrete headwall and inlet pipe at toe.

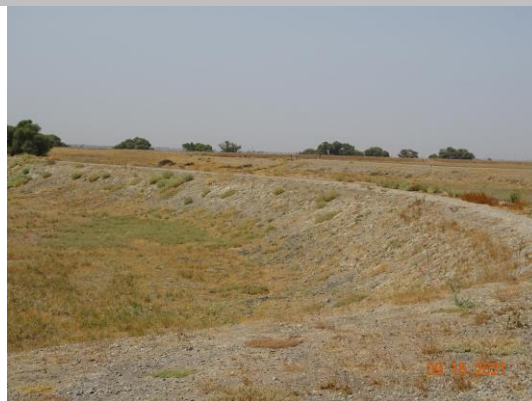
Photo 1 of 1 : FA\_2021\_NA0010\_128\_3\_20211005\_00004.jpg

LM Start	0.45	Rating **	A	Issue No.	3
LM End	0.45	Issue Type +	Ma	Location *	LS
Category	Earthen Levee			GPS Latitude/Longitude	
				Start	End
Item	Vegetation			37.219664 °	37.219664 °
				-120.703911 °	-120.703911 °
DWR ID	DWR_NA0010_10_f_2021_3				
Comment Code					
V1 : Control annual grass and weeds on the levee slopes and easements.					
Inspector Comment					
The annual vegetation is well maintained.

Looking downstream along the landside slope. (Fall 2021)

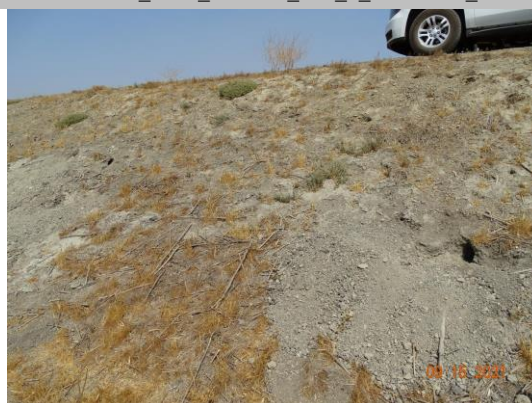
Photo 1 of 1 : FA\_2021\_NA0010\_128\_2\_20211006\_00005.jpg

LM Start	0.51	Rating **	M	Issue No.	2
LM End	0.51	Issue Type +	Ma	Location *	LS
Category	Earthen Levee			GPS Latitude/Longitude	
				Start	End
Item	Animal Control			37.219268 °	37.219268 °
				-120.703046 °	-120.703046 °
DWR ID	DWR_NA0010_10_f_2021_2				
Comment Code					
A3 : No rodents visible, but rodent burrows visible; need to backfill and compact or grout burrows.					
Inspector Comment

View squirrel holes on the landside slope. (Fall 2021)

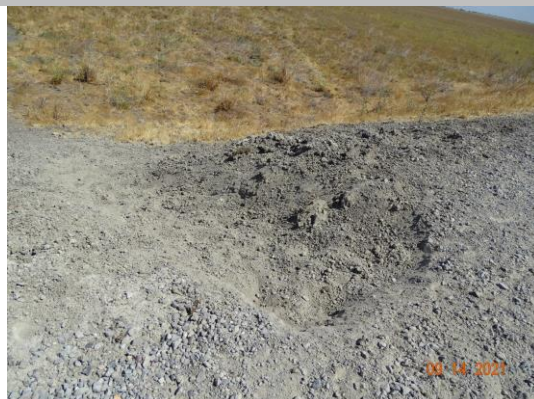
Photo 1 of 1 : FA\_2021\_NA0010\_129\_10\_20211006\_00035.jpg

LM Start	0.16	Rating **	M	Issue No.	10
LM End	0.16	Issue Type +	Ma	Location *	LS
Category	Earthen Levee			GPS Latitude/Longitude	
				Start	End
Item	Animal Control			37.202730 °	37.202730 °
				-120.752270 °	-120.752270 °
DWR ID	DWR_NA0010_11_f_2018_10				
Comment Code					
A2 : Repair the levee slope damaged by livestock and prevent large animal access.					
Inspector Comment					
Damage to the landside slope and shoulder.

View of livestock damage to the landside slope. (Fall 2021)

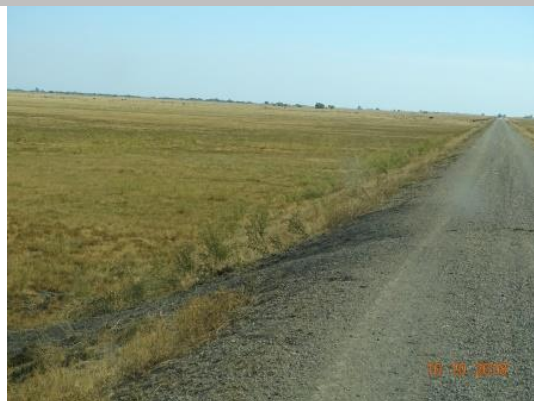
Photo 1 of 1 : FA\_2021\_NA0010\_129\_11\_20210830\_00003.jpg

LM Start	0.21	Rating **	A/W	Issue No.	11
LM End	0.21	Issue Type +	Ma	Location *	LS
Category	Earthen Levee			GPS Latitude/Longitude	
				Start	End
Item	Animal Control			37.202731 °	37.202731 °
				-120.751389 °	-120.751389 °
DWR ID	DWR_NA0010_11_f _ 2018_11				
Comment Code					
A2 : Repair the levee slope damaged by livestock and prevent large animal access.					
Inspector Comment					
Material has been placed on the levee damage. Monitor for settlement.

View of slope damage on landside. (Fall 2018)

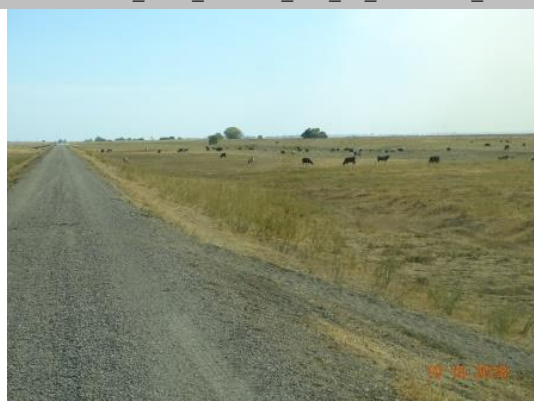
Photo 1 of 1 : FA\_2021\_NA0010\_129\_13\_20210830\_00006.jpg

LM Start	0.21	Rating **	A/W	Issue No.	13
LM End	0.21	Issue Type +	Ma	Location *	WS
Category	Earthen Levee			GPS Latitude/Longitude	
				Start	End
Item	Animal Control			37.202731 °	37.202731 °
				-120.751389 °	-120.751389 °
DWR ID	DWR_NA0010_11_s_2020_13				
Comment Code					
A2 : Repair the levee slope damaged by livestock and prevent large animal access.					
Inspector Comment					
Material has been placed on the levee damage. Monitor for settlement.

View of damage on waterside shoulder and slope. (Fall 2018)

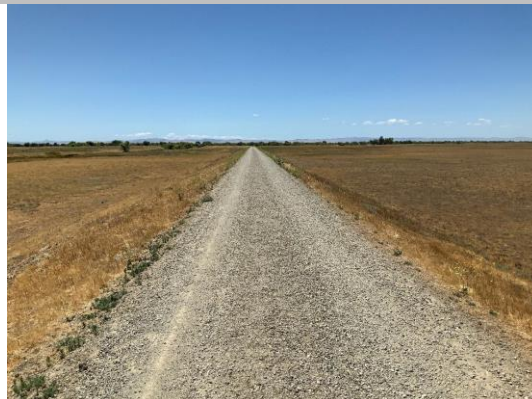
Photo 1 of 3 : UCIP\_FA\_2021\_67619\_100411.jpg

Comment Code						
Inspector Comment						
DS_ID:19846 FS_ID:67619 EP_NO: N/A Repair Type: Non-Urgent EVAL Issue: Limited Inspection/No UCIP Evaluation Crossing Status: Found UCIP Comments: 06/8/2021 The record remains Non-Urgent. WS pipe end either completely buried under dirt or has been removed. Only riser visible on WS slope, pipe end not visible at all. Recommend contacting owner to determine status of pipe. No permit was found authorizing this encroachment. CVFPB will need to review crossing to determine owner. The UCIP inspection was completed with GEI staff, P. Espinoza. (H. Dunn- GEI) 04/18/201 Need to contact owner. Recommend clearing sediment deposit inside pipe. (O. Magana - DWR UCIP) FIELD_STRUCT_DESC: 24-inch corrugated metal gravity drainage pipe through the levee, 11 feet below the crown. Slide gate in a corrugated metal pipe (CMP) riser on the waterside (WS) end. [Additional Reference(s): DWR Levee Log, 2002 (HLM 0.43), listed as a 24-inch corrugated metal pipe (CMP). USACE San Joaquin O&M Manual, Unit 601 Part 1 (SJR601.1), 1967, (HLM 0.42), listed as a 24-inch CMP]. FS Date: 6/8/2021

Levee crown looking downstream.

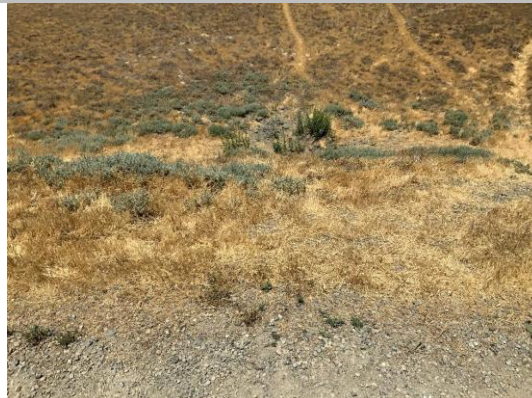
Photo 2 of 3 : UCIP\_FA\_2021\_67619\_100408.jpg

LS view: Toe from crown.

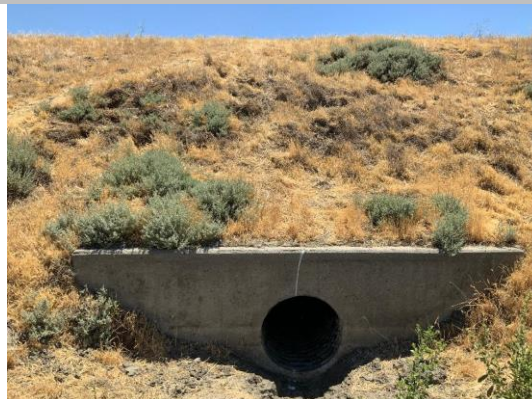
Photo 3 of 3 : UCIP\_FA\_2021\_67619\_100409.jpg

LS view: Slope and headwall at toe.

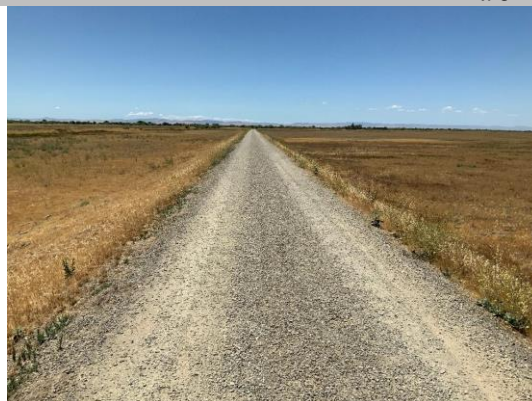
Photo 1 of 3 : UCIP\_FA\_2021\_67927\_100419.jpg

DS\_ID:19847  
 FS\_ID:67927  
 EP\_NO: N/A  
 Repair Type: Non-Urgent  
 EVAL Issue: Unauthorized Encroachment, installed decades prior  
 Crossing Status: Found  
 UCIP Comments: 06/8/2021 The record remains Non-Urgent. DWR DMP internal inspection has not found pipe integrity issues. LOF of crossing is less or equal to 4.0. Recommend next video inspection in 5 years. No permit was found authorizing this encroachment. CVFPB will need to review crossing to determine owner. The UCIP inspection was completed with GEI staff, P. Espinoza. (H. Dunn - GEI) 04/18/201  
 Need to contact owner. Recommend clearing sediment deposit inside pipe. (O. Magana - DWR UCIP)  
 FIELD\_STRUCT\_DESC: 24-inch corrugated metal gravity drainage pipe through the levee, 10 feet below the crown. Flap gate on the waterside (WS) end. [Additional Reference(s): DWR Levee Log, 2002 (HLM 0.65), listed as a 24-inch corrugated metal pipe (CMP). USACE San Joaquin O&M Manual, Unit 601 Part 1 (SJR601.1), 1967, (HLM 0.65), listed as a 24-inch CMP].

Levee crown looking downstream.

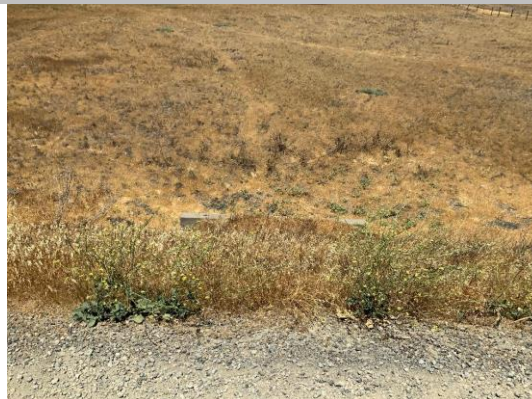
Photo 2 of 3 : UCIP\_FA\_2021\_67927\_100416.jpg

LS view: Headwall visible at toe from crown.

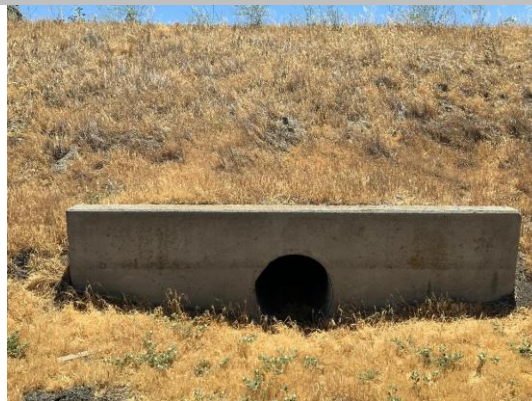
Photo 3 of 3 : UCIP\_FA\_2021\_67927\_100417.jpg

LS view: Slope and headwall at toe.

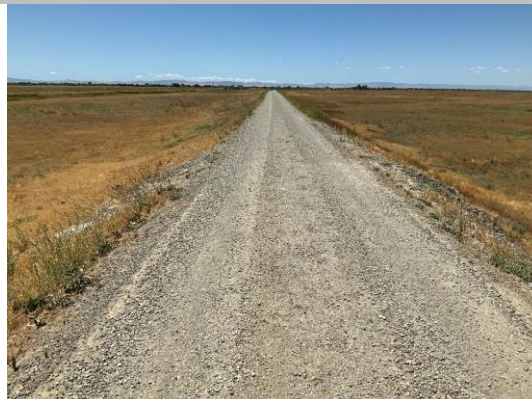
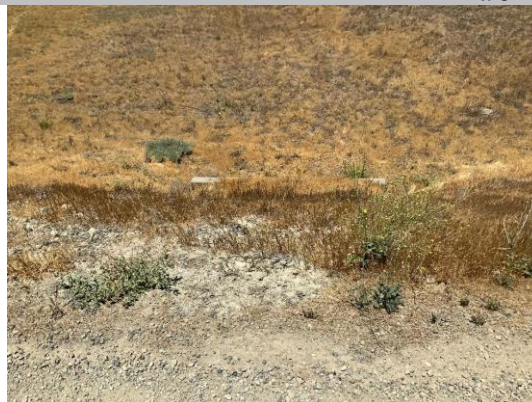
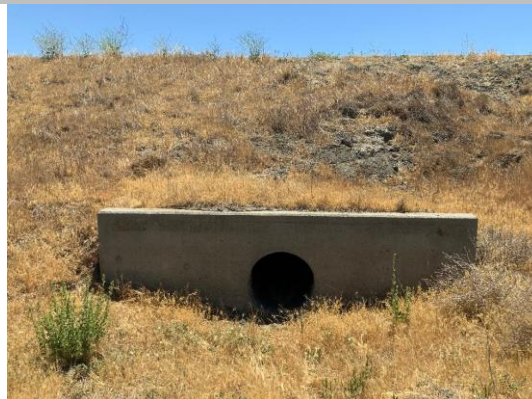
DS\_ID:19848  
FS\_ID:67621  
EP\_NO: N/A  
Repair Type: Non-Urgent  
EVAL Issue: Unauthorized Encroachment, installed decades prior  
Crossing Status: Found  
UCIP Comments: 06/8/2021 The record remains Non-Urgent. DWR DMP internal inspection has not found pipe integrity issues. LOF of crossing is less or equal to 4.0. Recommend next video inspection in 5 years. No permit was found authorizing this encroachment. CVFPB will need to review crossing to determine owner. The UCIP inspection was completed with GEI staff, P. Espinoza. (H. Dunn - GEI) 04/18/201  
Need to contact owner. Recommend clearing sediment deposit inside pipe. (O. Magana - DWR UCIP)  
FIELD\_STRUCT\_DESC: 24-inch corrugated metal gravity drainage pipe through the levee, 10.3 feet below the crown. Flap gate on the waterside (WS) end. [Additional Reference(s): DWR Levee Log, 2002 (HLM 0.85), listed as a 24-inch corrugated metal pipe (CMP). USACE San Joaquin O&M Manual, Unit 601 Part 1 (SJR601.1), 1967, (HLM 0.84), listed as a 24-inch CMP].

Levee crown looking downstream.

LS view: Toe from crown.

LS view: Headwall and slope from toe.

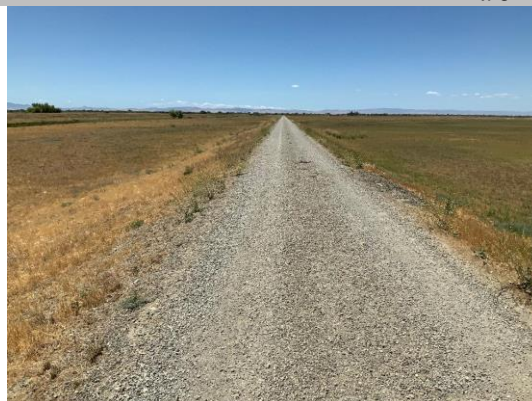
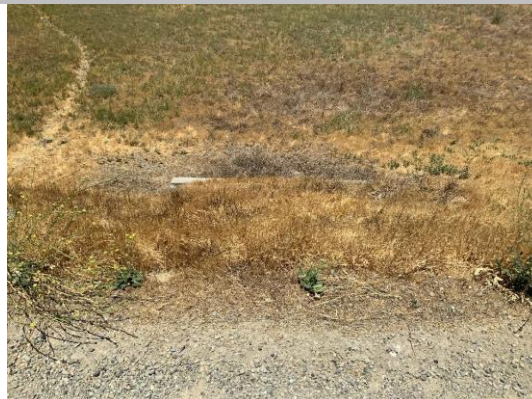
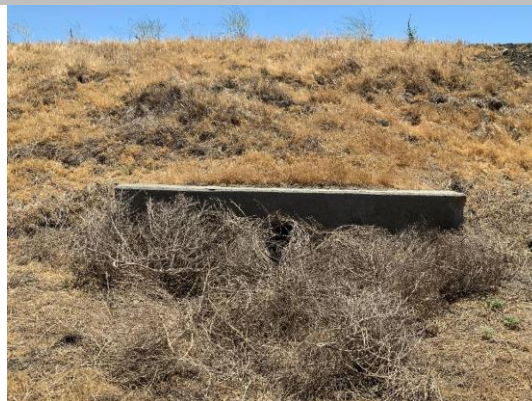
DS\_ID:19849  
 FS\_ID:67622  
 EP\_NO: N/A  
 Repair Type: Non-Urgent  
 EVAL Issue: Limited Inspection/No UCIP Evaluation  
 Crossing Status: Found  
 UCIP Comments: 06/8/2021 The record remains Non-Urgent. DWR DMP internal inspection has not found pipe integrity issues. LOF of crossing is less or equal to 4.0. Recommend next video inspection in 5 years. Dense tumbleweeds blocking both LS and WS ends, recommend removal. No permit was found authorizing this encroachment. CVFPB will need to review crossing to determine owner. The UCIP inspection was completed with GEI staff, P. Espinoza. (H. Dunn - GEI) 04/18/2014 Need to contact owner. Recommend clearing sediment deposit inside pipe. (O. Magana - DWR UCIP)  
 FIELD\_STRUCT\_DESC: 24-inch corrugated metal gravity drainage pipe through the levee, 9 feet below the crown. Flap gate on the waterside (WS) end. [Additional Reference(s): DWR Levee Log, 2002 (HLM 1.13), listed as a 24-inch corrugated metal pipe (CMP). USACE San Joaquin O&M Manual, Unit 601 Part 1 (SJR601.1), 1967, (HLM 1.13), listed as a 24-inch CMP].

Levee crown looking downstream.

LS view: Headwall visible at toe from crown.

LS view: Headwall and slope at toe.

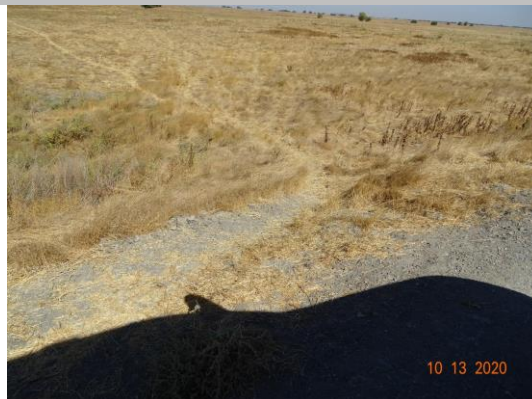
Photo 1 of 1 : FA\_2021\_NA0010\_129\_9\_20210830\_00001.jpg

View of livestock trail on the landside slope. (Fall 2020)

LM Start	1.49	Rating **	A/W	Issue No.	9
LM End	1.49	Issue Type +	Ma	Location *	LS
Category	Earthen Levee			GPS Latitude/Longitude	
				Start	End
Item	Animal Control			37.202748 °	37.202748 °
				-120.728182 °	-120.728182 °
DWR ID	DWR_NA0010_11_f_2017_9				
Comment Code					
A2 : Repair the levee slope damaged by livestock and prevent large animal access.					
Inspector Comment

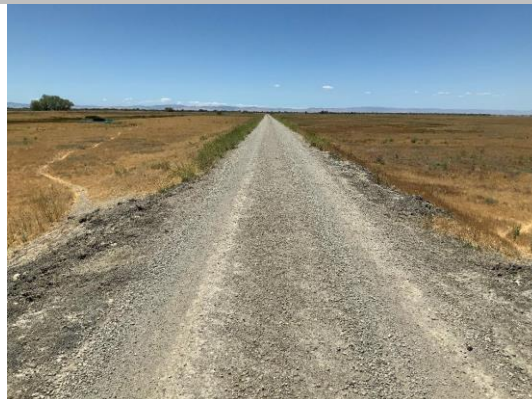
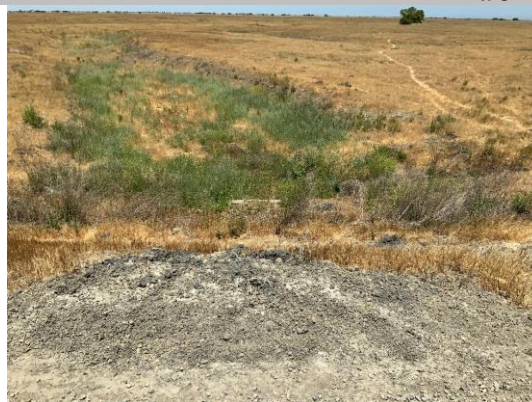
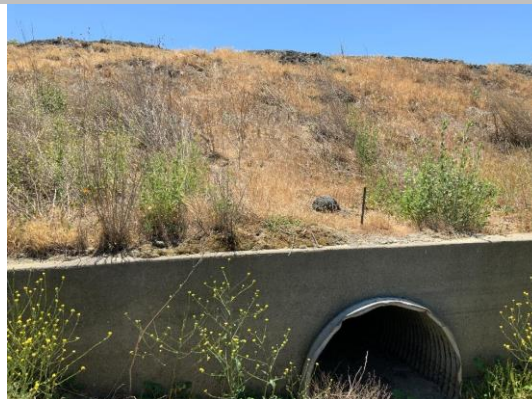
DS\_ID:19850  
FS\_ID:67623  
EP\_NO: N/A  
Repair Type: Non-Urgent  
EVAL Issue: Maintenance Compliance Issue  
Crossing Status: Found  
UCIP Comments: 06/8/2021 The record remains Non-Urgent. Sediment buildup in both WS and LS pipe inlet and outlet, recommend clearing out. WS pipe edges are slightly warped. No permit was found authorizing this encroachment. CVFPB will need to review crossing to determine owner. The UCIP inspection was completed with GEI staff, P. Espinoza. (H. Dunn - GEI)  
04/18/2014 Need to contact owner. Recommend clearing sediment deposit inside pipe. (O. Magana - DWR UCIP)  
FIELD\_STRUCT\_DESC: 48-inch corrugated metal gravity drainage pipe through the levee, 16.3 feet below the crown. Slide gate in a pipe riser on the waterside (WS) slope. [Additional Reference(s): DWR Levee Log, 2002 (HLM 1.50), listed as a 48-inch corrugated metal pipe (CMP). USACE San Joaquin O&M Manual, Unit 601 Part 1 (SJR601.1), 1967, (HLM 1.50), listed as a 48-inch CMP].

Levee crown looking downstream.

LS view: Headwall visible at toe from crown.

LS view: Slope and headwall from toe.

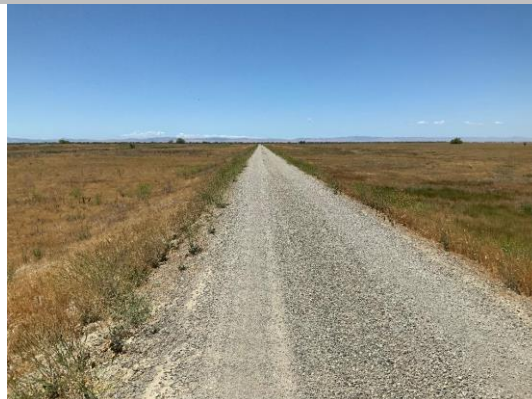
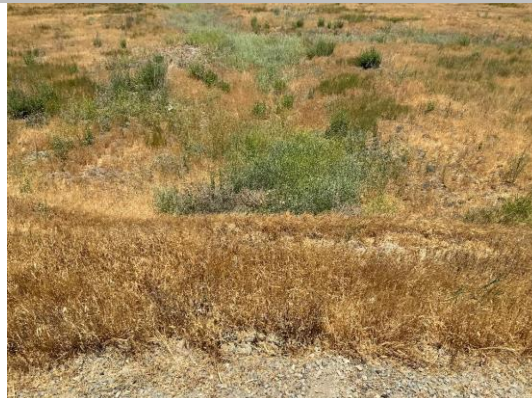
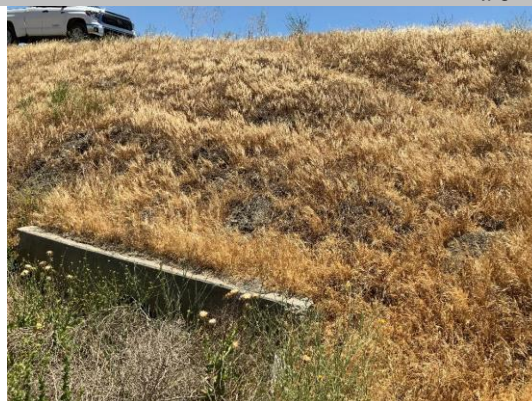
Comment Code					
Inspector Comment					
DS_ID:19851 FS_ID:67624 EP_NO: N/A Repair Type: Non-Urgent EVAL Issue: Pipe Damage Crossing Status: Found UCIP Comments: 06/8/2021 The record remains Non-Urgent. DWR DMP internal inspection has found pipe integrity issues. LOF of crossing is between 4.1 and 5. Crossing will be monitored until funding becomes available for rehabilitation. Vegetation on both WS and LS ends, recommend removal. No permit was found authorizing this encroachment. CVFPB will need to review crossing to determine owner. The UCIP inspection was completed with GEI staff, P. Espinoza. (H. Dunn - GEI) 04/18/201 Need to contact owner. Recommend clearing sediment deposit inside pipe. (O. Magana - DWR UCIP) FIELD_STRUCT_DESC: 24-inch corrugated metal gravity drainage pipe through the levee, 12.8 feet below the crown. Flap gate on the waterside (WS) end. [Additional Reference(s): DWR Levee Log, 2002 (HLM 1.99), listed as a 24-inch corrugated metal pipe (CMP). USACE San Joaquin O&M Manual, Unit 601 Part 1 (SJR601.1), 1967, (HLM 1.99), listed as a 24-inch CMP]. FS Date: 6/8/2021

Levee crown looking downstream.

LS view: Toe from crown.

LS view: Headwall and slope from toe.

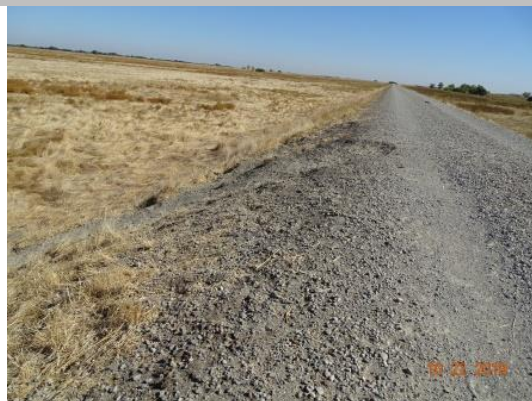
Photo 1 of 1 : FA\_2021\_NA0010\_129\_17\_20210830\_00007.jpg

Damage to the landside slope from livestock traffic. (Fall 2019)

LM Start	2.31	Rating **	M	Issue No.	17
LM End	2.31	Issue Type +	Ma	Location *	LS
Category	Earthen Levee			GPS Latitude/Longitude	
				Start	End
Item	Animal Control			37.202730 °	37.202730 °
				-120.713368 °	-120.713368 °
DWR ID	DWR_NA0010_11_f_2019_17				
Comment Code					
A2 : Repair the levee slope damaged by livestock and prevent large animal access.					
Inspector Comment

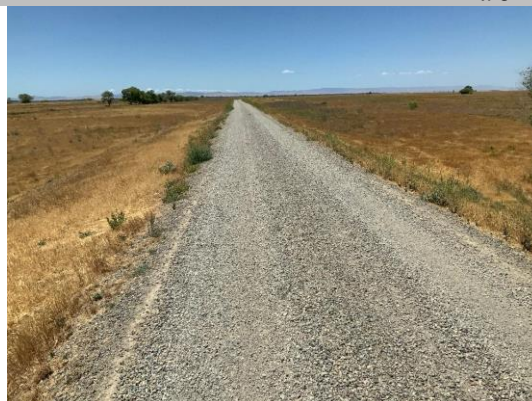
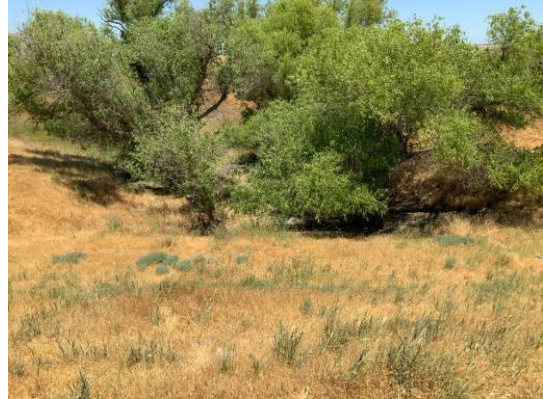
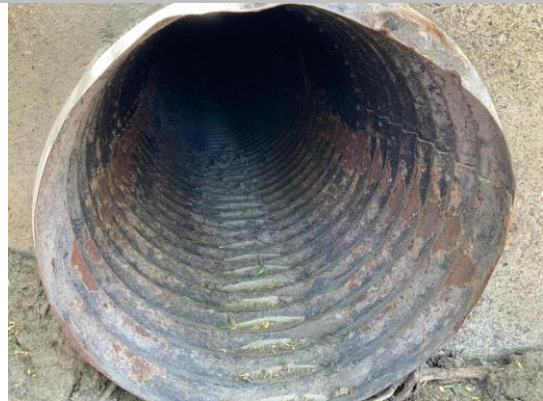
DS\_ID:19852  
 FS\_ID:67928  
 EP\_NO: N/A  
 Repair Type: Urgent  
 EVAL Issue: Pipe Integrity  
 Crossing Status: Found  
 UCIP Comments: 06/8/2021 The record has been upgraded from Non-Urgent to Urgent. DWR DMP internal inspection has found pipe integrity issues. LOF of crossing is between 5 and 6. Crossing will be monitored until funding becomes available to address the issues. No permit was found authorizing this encroachment. CVFPB will need to review crossing to determine owner. Pipe has since been cleared out of sediment since previous inspection. The UCIP inspection was completed with GEI staff, P. Espinoza. (H. Dunn- GE)04/18/201 Need to contact owner. Recommend clearing sediment deposit inside pipe. (O. Magana - DWR UCIP)  
 FIELD\_STRUCT\_DESC: 24-inch corrugated metal gravity drainage pipe through the levee, 15 feet below the crown. Flap gate on the waterside (WS) end. [Additional Reference(s): DWR Levee Log, 2002 (HLM 3.04), listed as a 24-inch corrugated metal pipe (CMP). USACE San Joaquin O&M Manual, Unit 601 Part 1 (SJR601.1), 1967, (HLM 3.04), listed as a 24-inch CMP].

Levee crown looking downstream.

LS view: Toe from crown.

LS view: Close up of pipe inlet at toe.

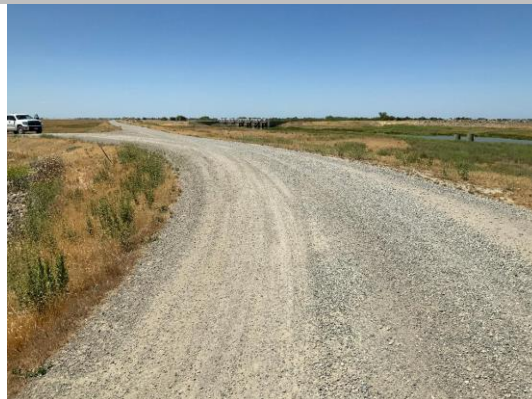
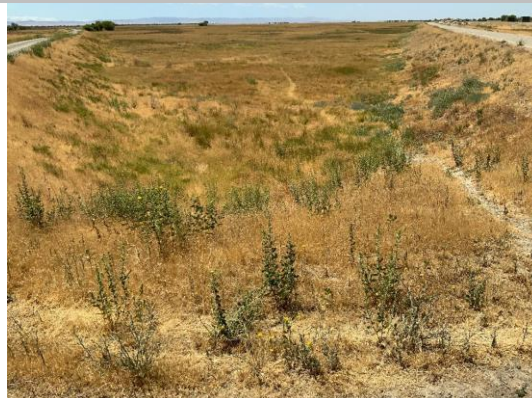
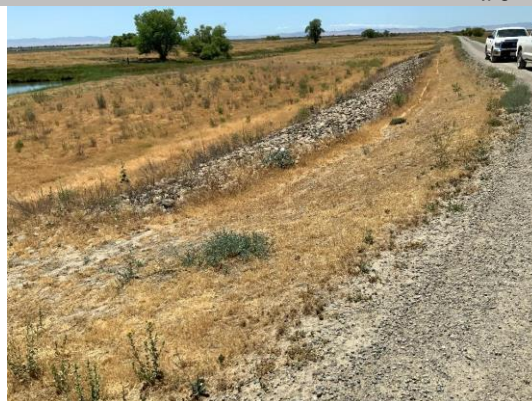
Comment Code					
Inspector Comment					
DS_ID:25542 FS_ID:67929 EP_NO: N/A Repair Type: Non-Urgent EVAL Issue: Pipe Not Found Crossing Status: Not Found UCIP Comments: 06/8/2021 The record is Non-Urgent. Pipe not found by visual inspection. This appears to potentially be inside a different unit based on the CLM since this unit only goes from CLM 0 to 3.31. Either way, it was not observed in the field. Recommend contacting owner to determine status of pipe. No permit was found authorizing this encroachment. CVFPB will need to review crossing to determine owner. The UCIP inspection was completed with GEI staff, P. Espinoza. (H. Dunn- GEI)09/23/202 UCIP record brought online. Confirm location. (O. Magana - DWR UCIP) FIELD_STRUCT_DESC: 24-inch corrugated metal drainage pipe through the levee, 15.0 feet below the crown. Flap gate on the waterside (WS) end. [Additional Reference(s): DWR Levee Log, 2002 (HLM 3.32), listed as a 24-inch corrugated metal pipe (CMP). USACE San Joaquin O&M Manual, Unit 601 Part 1 (SJR601.1), 1967, (HLM 3.32), listed as a 24-inch CMP]. FS Date: 6/8/2021

Levee crown on adjacent unit bisecting this one.

LS view: Slope from toe, no pipe visible.

WS view: Slope from toe, no pipe visible.
