## Flood Control Project Maintenance Levee Inspections

### Fall 2021 Levee Maintenance Deficiency Summary Report

#### San Joaquin River Basin

NA0010 Lower San Joaquin Levee District	Overall LMA Rating	Total LMA Miles							
	U	191.27							
Rated Item	Maintenance Deficiency				Enforcement		Design & System Obsolescence		
	M Miles	U Miles	M + 4U Miles	Threshold %	M Miles	U Miles	M Miles	U Miles	
<i>Earthen Levee</i>									
Vegetation	47.00	9.57	85.28	44.59%					
Trim / Thin Trees	0.10		0.10	0.05%					
Encroachments	0.23	0.02	0.31	0.16%	9.29	0.59			
Animal Control	7.67	2.19	16.43	8.59%					
Slope Stability	0.05	0.01	0.09	0.05%					
Erosion / Bank Caving	0.13	0.81	3.37	1.76%					
Crown Surface / Depressions / Rutting	0.01		0.01	0.01%					
Repair Gates	0.02	0.02	0.10	0.05%					
<i>Rivers, Channels &amp; Designated Floodways</i>									
Encroachments					0.01	0.01			
<i>Supplemental</i>									
DWR Erosion Survey	0.12	0.17	0.80	0.42%					
DWR UCIP Field Study					1.29	0.05			
DWR UCIP LMA Responsibility									
<i>LMA Totals:</i>	55.33	12.79	106.49	55.67%	10.59	0.65	0.00	0.00

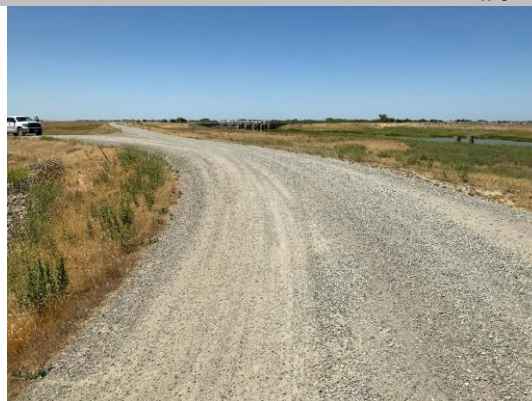
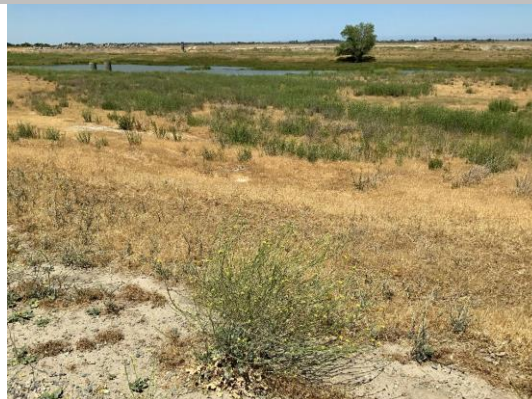
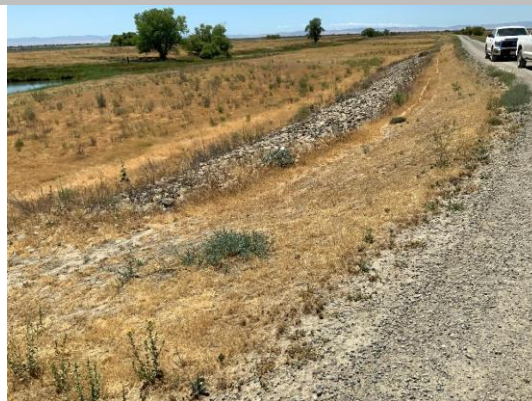
DS\_ID:25543  
 FS\_ID:67931  
 EP\_NO: N/A  
 Repair Type: Non-Urgent  
 EVAL Issue: Pipe Not Found  
 Crossing Status: Not Found  
 UCIP Comments: 06/06/2021 The record is Non-Urgent. Pipe not found by visual inspection. This appears to potentially be inside a different unit based on the CLM since this unit only goes from CLM 0 to 3.31. Either way, it was not observed in the field. Recommend contacting owner to determine status of pipe. No permit was found authorizing this encroachment. CVFPB will need to review crossing to determine owner. The UCIP inspection was completed with GEI staff, P. Espinoza. (H. Dunn – GEI)09/23/2020 UCIP record brought online. Confirm location. (O. Magana - DWR UCIP)  
 FIELD\_STRUCT\_DESC: [Eastside Canal Siphon] 48-inch corrugated metal pipe through the levee, 16.0 feet below the crown and under channel. Slide gate on landside (LS) end. [Additional Reference(s): DWR Levee Log, 2002 (HLM 3.33), listed as a 48-inch corrugated metal pipe (CMP). USACE San Joaquin O&M Manual, Unit 601 Part 1 (SJR601.1), 1967, (HLM 3.33), listed as a 48-inch CMP].

Levee crown of bisecting unit section.

LS view: Slope from crown, no pipe visible.

WS view: Slope from crown, no pipe visible.

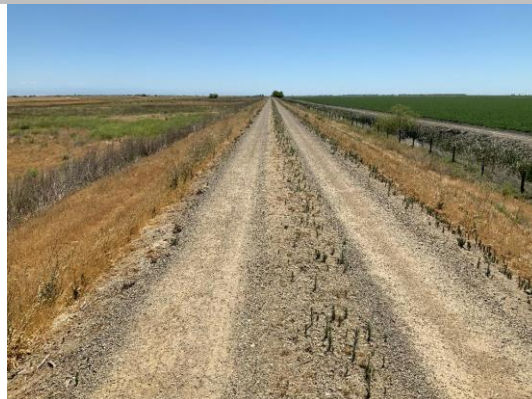
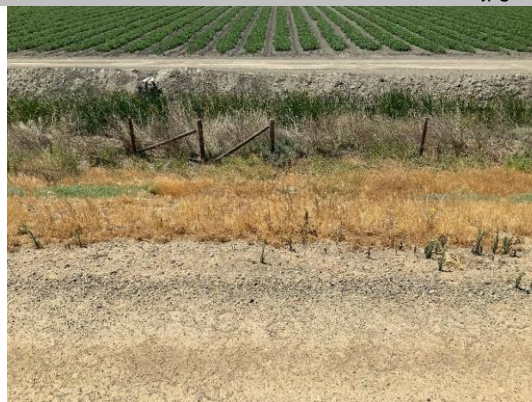
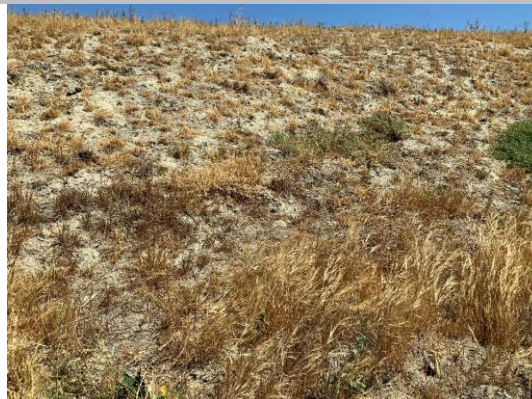
DS\_ID:19855  
FS\_ID:67726  
EP\_NO: N/A  
Repair Type: Non-Urgent  
EVAL Issue: Unauthorized Encroachment, installed decades prior  
Crossing Status: Found  
UCIP Comments: 06/8/2021 The record remains Non-Urgent. DWR DMP internal inspection has not found pipe integrity issues. LOF of crossing is less or equal to 4.0. Recommend next video inspection in 5 years. No permit was found authorizing this encroachment. CVFPB will need to review crossing to determine owner. The UCIP inspection was completed with GEI staff, P. Espinoza. (H. Dunn – GEI) 04/18/2014  
Need to contact owner. Dense vegetation limits the inspector's visibility to identify signs of pipe failure (leaks) along the waterward slope. Recommend removing vegetation along pipe alignment to conduct proper inspection of structure. (O. Magana - DWR UCIP)  
FIELD\_STRUCT\_DESC: 24-inch corrugated metal gravity drainage pipe through the levee, 10.5 feet below the crown. Flap gate on the waterside (WS) end. [Additional Reference(s): DWR Levee Log, 2002 (HLM 0.41), listed as a 24-inch corrugated metal pipe (CMP). USACE San Joaquin O&M Manual, Unit 601 Part 1 (SJR601.1), 1967, (HLM 0.39), listed as a 24-inch CMP].

Levee crown looking downstream.

LS view: Toe from crown.

LS view: Slope from toe.

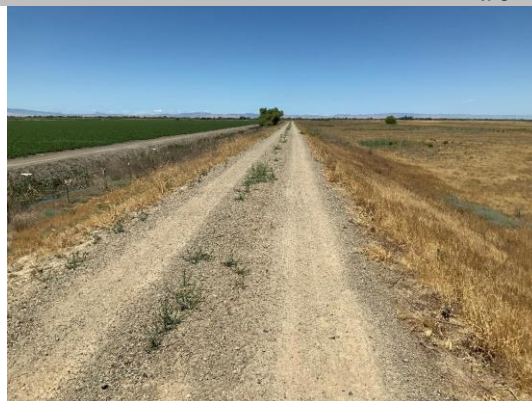
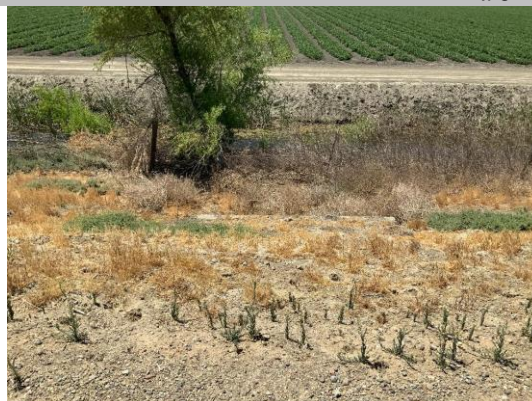
DS\_ID:19856  
 FS\_ID:68233  
 EP\_NO: N/A  
 Repair Type: Non-Urgent  
 EVAL Issue: Maintenance Compliance Issue  
 Crossing Status: Found  
 UCIP Comments: 06/8/2021 The record remains Non-Urgent. DWR DMP internal inspection has not found pipe integrity issues. LOF of crossing is less or equal to 4.0. Recommend next video inspection in 5 years. Some vegetation growth starting over WS flapgate and LS pipe inlet, recommend removal. No permit was found authorizing this encroachment. CVFPB will need to review crossing to determine owner. The UCIP inspection was completed with GEI staff, P. Espinoza. (H. Dunn – GEI) 04/18/2014 Need to contact owner. Recommend clearing sediment deposit inside pipe. (O. Magana - DWR UCIP)  
 FIELD\_STRUCT\_DESC: 24-inch corrugated metal gravity drainage pipe through the levee, 10.5 feet below the crown. Flap gate on the waterside (WS) end. [Additional Reference(s): DWR Levee Log, 2002 (HLM 1.06), listed as a 24-inch corrugated metal pipe (CMP). USACE San Joaquin O&M Manual, Unit 601 Part 1 (SJR601.1), 1967, (HLM 1.06), listed as a 24-inch CMP].

Levee crown looking upstream.

LS view: Headwall visible at toe from crown.

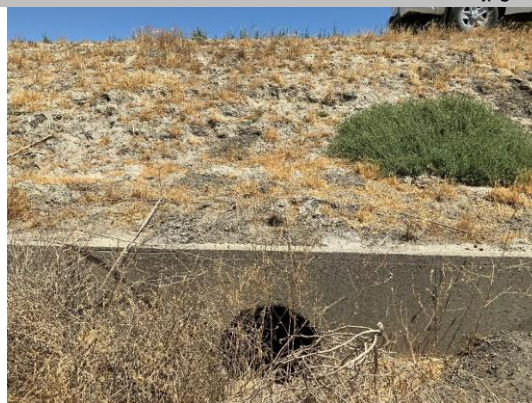
Photo 3 of 3 : UCIP\_FA\_2021\_68233\_100631.jpg

LM Start	<b>1.06</b>	Rating **	M	Issue No.	<b>16 (cont)</b>
LM End	<b>1.06</b>	Issue Type +	Ma	Location *

LS view: Slope and headwall at toe.

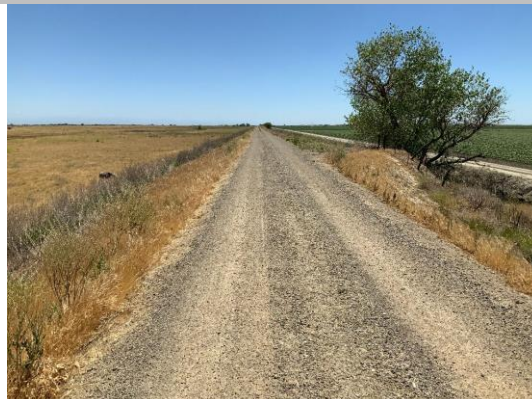
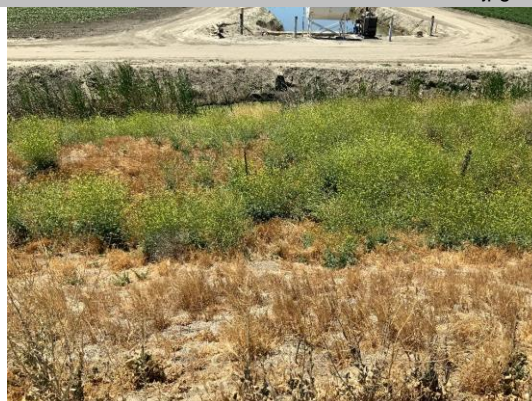
DS\_ID:19857  
FS\_ID:67728  
EP\_NO: N/A  
Repair Type: Non-Urgent  
EVAL Issue: Limited Inspection/No UCIP Evaluation  
Crossing Status: Not Found  
UCIP Comments: 06/8/2021 The record remains Non-Urgent. Pipe not found during visual inspection due to dense vegetation on both WS and LS ends. LS end was also blocked off by barbed wire which limited inspection. Recommend removing vegetation in order to assess condition of pipe. No permit was found authorizing this encroachment. CVFPB will need to review crossing to determine owner. The UCIP inspection was completed with GEI staff, P. Espinoza. (H. Dunn – GEI)

04/18/2014 Landward side not accessible due to dense vegetation and fence. Concrete headwall and flap gate under water therefore not able to evaluate condition. Will need to coordinate with owner to evaluate condition of crossing on waterward side and obtain access to evaluate landward side. (O. Magana - DWR UCIP)

Levee crown looking downstream.

LS view: Toe from crown.

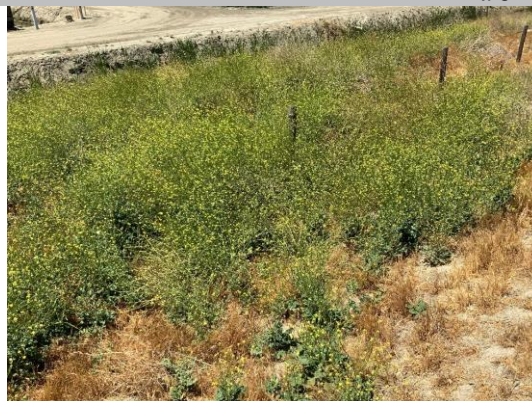
Photo 3 of 3 : UCIP\_FA\_2021\_67728\_100638.jpg

LM Start	<b>1.27</b>	Rating **	M	Issue No.	<b>17 (cont)</b>
LM End	<b>1.27</b>	Issue Type +	En	Location *	
Category	Supplemental		GPS Latitude/Longitude		
			Start	End	
Item	DWR UCIP Field Study		37.200919 °	37.200919 °	
			-120.732234 °	-120.732234 °	
DWR ID	19857

LS view: Dense vegetation and barbed wire at the toe, no pipe visible.

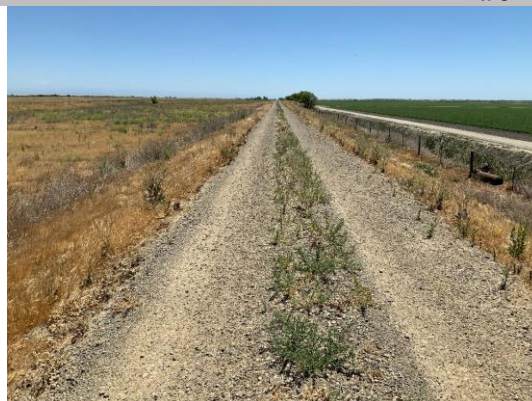
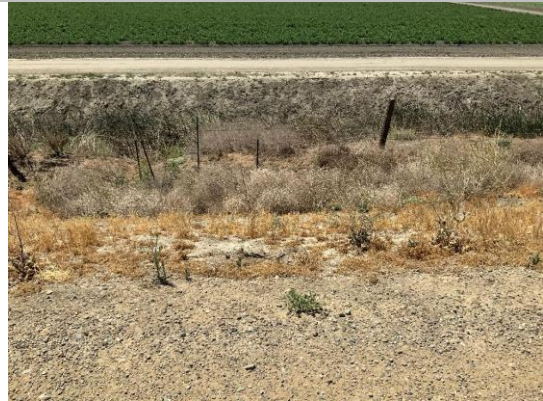
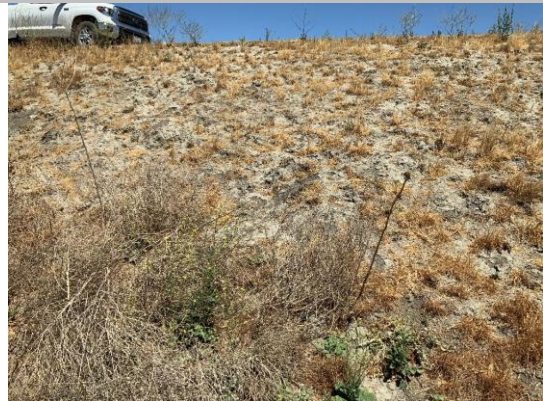
DS\_ID:19858  
FS\_ID:67729  
EP\_NO: N/A  
Repair Type: Non-Urgent  
EVAL Issue: Limited Inspection/No UCIP Evaluation  
Crossing Status: Found  
UCIP Comments: 06/8/2021 The record remains Non-Urgent. DWR DMP internal inspection has not found pipe integrity issues. LOF of crossing is less or equal to 4.0. Recommend next video inspection in 5 years. Dense vegetation over LS pipe inlet, headwall barely visible. Recommend removal of vegetation. No permit was found authorizing this encroachment. CVFPB will need to review crossing to determine owner. The UCIP inspection was completed with GEI staff, P. Espinoza. (H. Dunn – GEI) 04/18/2014 Limited access on landward side due to fence and dense vegetation. Recommend obtaining access to landward side and clear vegetation on landward side. (O. Magana - DWR UCIP)  
FIELD\_STRUCT\_DESC: 24-inch corrugated metal gravity drainage pipe through the levee, 10.7 feet below the crown. Flap gate on the waterside (WS) end. [Additional Reference(s): DWR Levee Log, 2002 (HLM 1.53), listed as a 24-inch corrugated metal pipe (CMP). USACE San Joaquin O&M Manual, Unit 601 Part 1 (SJR601.1), 1967, (HLM 1.53), listed as a 24-inch CMP].

Levee crown looking upstream.

LS view: Toe from crown.

LS view: Slope from toe.

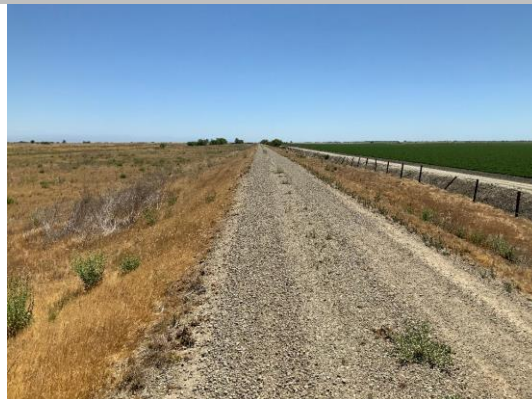
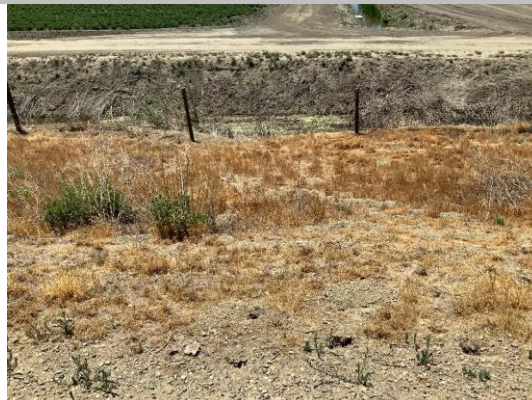
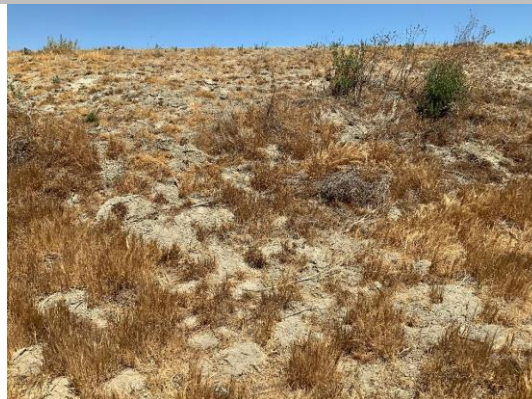
DS\_ID:19859  
FS\_ID:68234  
EP\_NO: N/A  
Repair Type: Non-Urgent  
EVAL Issue: Limited Inspection/No UCIP Evaluation  
Crossing Status: Found  
UCIP Comments: 06/8/2021 The record remains Non-Urgent. DWR DMP internal inspection has not found pipe integrity issues. LOF of crossing is less or equal to 4.0. Recommend next video inspection in 5 years. LS pipe inlet inaccessible due to barbed wire, just the top of the headwall visible. No permit was found authorizing this encroachment. CVFPB will need to review crossing to determine owner. The UCIP inspection was completed with GEI staff, P. Espinoza. (H. Dunn – GEI)

04/18/2014 Need to contact owner. Recommend clearing vegetation from landward side--headwall blocked. (O. Magana - DWR UCIP)  
FIELD\_STRUCT\_DESC: 24-inch corrugated metal gravity drainage pipe through the levee, 14.4 feet below the crown. Flap gate on the waterside (WS) end. [Additional Reference(s): DWR Levee Log, 2002 (HLM 2.16), listed as a 24-inch corrugated metal pipe (CMP). USACE San Joaquin O&M Manual, Unit 601 Part 1 (SJR601.1), 1967, (HLM 2.16), listed as a 24-inch CMP].  
FS Date: 6/8/2021

Levee crown looking upstream.

LS view: Toe from crown.

LS view: Slope from toe.

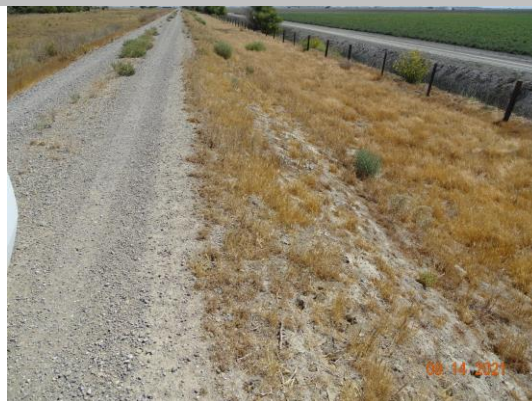
Photo 1 of 1 : FA\_2021\_NA0010\_130\_9\_20211006\_00025.jpg

LM Start	2.51	Rating **	A	Issue No.	9
LM End	2.51	Issue Type +	Ma	Location *	LS
Category	Earthen Levee			GPS Latitude/Longitude	
				Start	End
Item	Vegetation			37.200918 °	37.200918 °
				-120.709659 °	-120.709659 °
DWR ID	DWR_NA0010_12_f _ 2021_9				
Comment Code					
V1 : Control annual grass and weeds on the levee slopes and easements.					
Inspector Comment					
The annual vegetation is well maintained.

View of landside slope looking upstream. (Fall 2021)

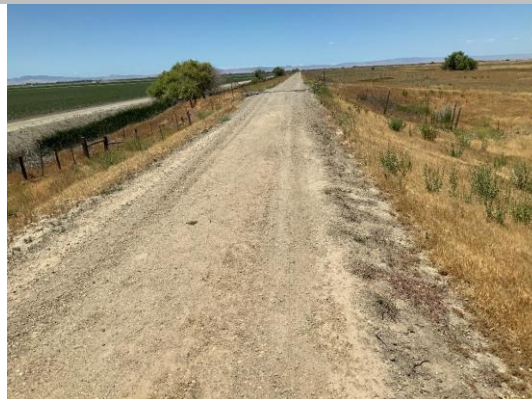
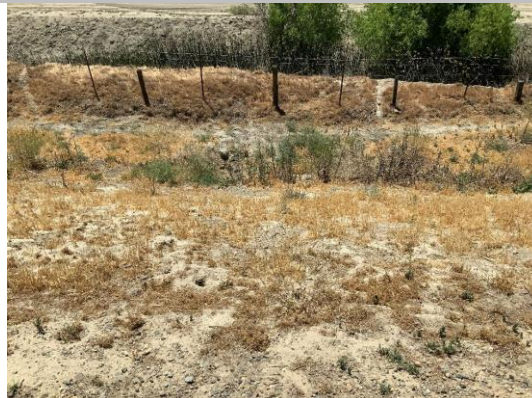
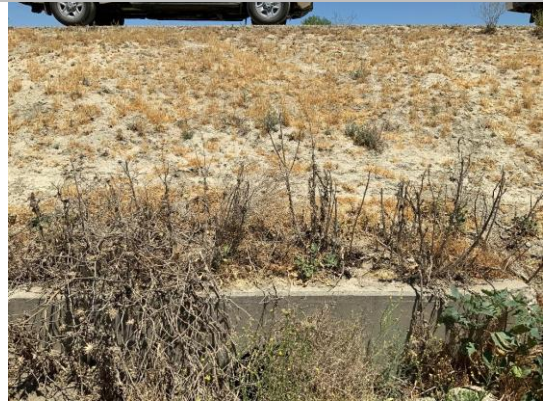
DS\_ID:19860  
FS\_ID:67731  
EP\_NO: N/A  
Repair Type: Non-Urgent  
EVAL Issue: Limited Inspection/No UCIP Evaluation  
Crossing Status: Found  
UCIP Comments: 06/8/2021 The record remains Non-Urgent. DWR DMP internal inspection has not found pipe integrity issues. LOF of crossing is less or equal to 4.0. Recommend next video inspection in 5 years. LS pipe inlet covered with vegetation, recommend removal. No permit was found authorizing this encroachment. CVFPB will need to review crossing to determine owner. The UCIP inspection was completed with GEI staff, P. Espinoza. (H. Dunn – GEI) 04/18/2014 Need to contact owner. Recommend clearing sediment deposit inside pipe. (O. Magana - DWR UCIP)  
FIELD\_STRUCT\_DESC: 24-inch corrugated metal gravity drainage pipe through the levee, 10.7 feet below the crown. Flap gate on the waterside (WS) end. [Additional Reference(s): DWR Levee Log, 2002 (HLM 2.70), listed as a 24-inch corrugated metal pipe (CMP). USACE San Joaquin O&M Manual, Unit 601 Part 1 (SJR601.1), 1967, (HLM 2.70), listed as a 24-inch CMP].

Levee crown looking upstream.

LS view: Toe from crown.

LS view: Headwall and slope from toe.

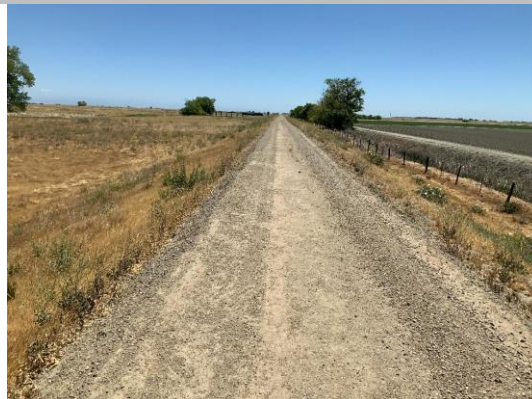
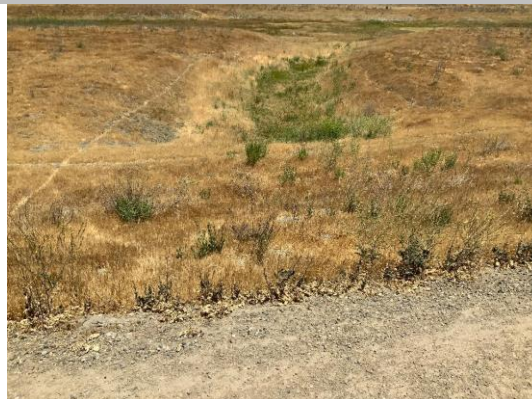
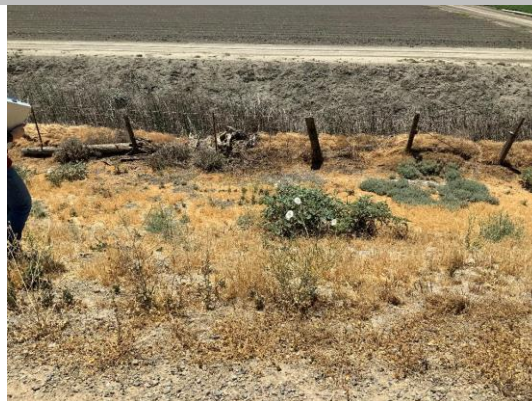
DS\_ID:19861  
FS\_ID:68235  
EP\_NO: N/A  
Repair Type: Non-Urgent  
EVAL Issue: Limited Inspection/No UCIP Evaluation  
Crossing Status: Found  
UCIP Comments: 06/8/2021 The record remains Non-Urgent. DWR DMP internal inspection has not found pipe integrity issues. LOF of crossing is less or equal to 4.0. Recommend next video inspection in 5 years. LS pipe inlet inaccessible due to barbed wire and WS flapgate surrounded by water, limited inspection for both. LS pipe inlet also has dense vegetation covering it, recommend removal. No permit was found authorizing this encroachment. CVFPB will need to review crossing to determine owner. The UCIP inspection was completed with GEI staff, P. Espinoza. (H. Dunn – GEI) 11/09/2015 DWR Inspection section confirmed issue has been addressed. Need to coordinate with LMA to determine additional details for extent of repair. (O. Magana - DWR UCIP)04/18/2014 Soil missing behind concrete headwall on waterward side. Unable to determine if missing soil is due to sink holes, rodent activity, or due to erosion. Headwall appears to be leaning slightly forward. Reason why this crossing was labelled urgent was due to the uncertainty of damage to concrete headwall and reason for soil missing behind concrete. Need to coordinate with LMA to determine more information about repair at this location. (O. Magana -DWR UCIP) FIELD\_STRUCT\_DESC: 24-inch corrugated metal gravity drainage pipe through the levee, 2 feet below the crown. Flap gate on the waterside (WS) end. [Additional Reference(s): DWR Levee Log, 2002 (HLM 3.00), listed as a 24-inch corrugated metal pipe (CMP). USACE San Joaquin O&M Manual, Unit 601 Part 1 (SJR601.1), 1967, (HLM 3.00), listed as a 24-inch CMP].

Levee crown looking upstream.

LS view: Toe from crown.

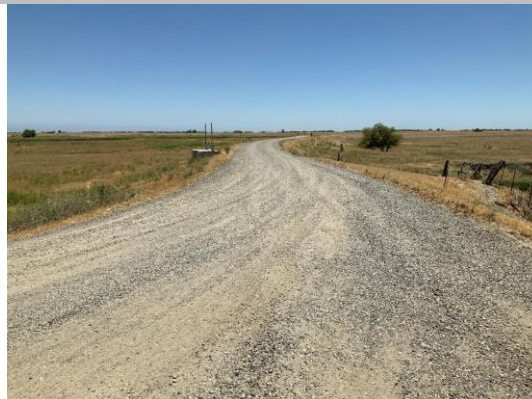
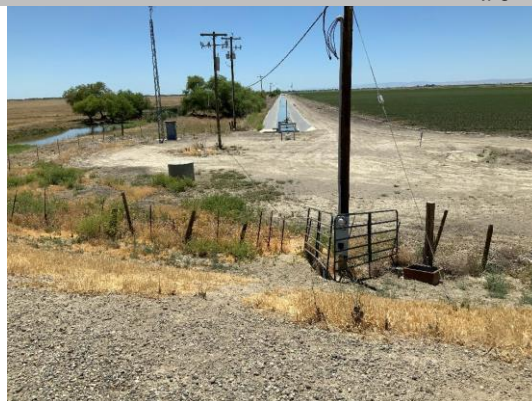
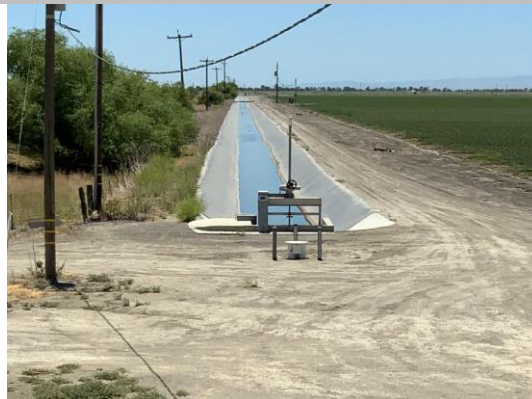
DS\_ID:19906  
FS\_ID:68237  
EP\_NO: N/A  
Repair Type: Non-Urgent  
EVAL Issue: Limited Inspection/No UCIP Evaluation  
Crossing Status: Indicator Found  
UCIP Comments: 06/8/2021 The record remains Non-Urgent. The slidegate and canal are visible on the LS from the crown, but inaccessible due to fence. Unable to measure and confirm whether the slidegate goes to this crossing. Pipe goes under channel, so not visible on WS. Confirm with owner on the status of this pipe. No permit was found authorizing this encroachment. CVFPB will need to review crossing to determine owner. The UCIP inspection was completed with GEI staff, P. Espinoza. (H. Dunn – GEI) 04/18/2014 Unable to confirm if crossing recorded as Unit 6 9.735 is the same as this one. No way to measure diameter crossing has slide gate on landward side. (O. Magana - DWR UCIP)  
FIELD\_STRUCT\_DESC: [Eastside Canal Siphon] 48-inch corrugated metal irrigation siphon pipe through the levee and under the channel, 17.5 feet below the crown. Slide gate on the landside (LS). [Additional Reference(s): DWR Levee Log, 2002 (HLM 3.36), listed as a 48-inch corrugated metal pipe (CMP). USACE San Joaquin O&M Manual, Unit 601 Part 1 (SJR601.1), 1967, (HLM 3.36), listed as a 48-inch CMP].

Levee crown looking upstream.

LS view: Toe from crown.

LS view: Close up of slidegate and canal at toe.

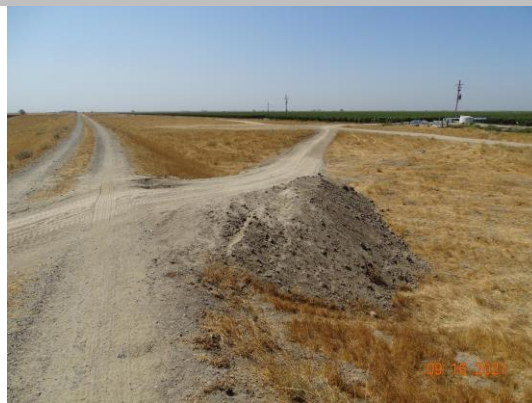
Photo 1 of 1 : FA\_2021\_NA0010\_131\_9\_20211006\_00012.jpg

LM Start	0.48	Rating **	M	Issue No.	9
LM End	0.48	Issue Type +	En	Location *	LS
Category	Earthen Levee			GPS Latitude/Longitude	
				Start	End
Item	Encroachments			37.040343 °	37.040343 °
				-120.439316 °	-120.439316 °
DWR ID	DWR_NA0010_13_f_2021_9				
Comment Code					
RA : Ramp					
Inspector Comment

Unauthorized ramp constructed on the landside slope. (Fall 2021)

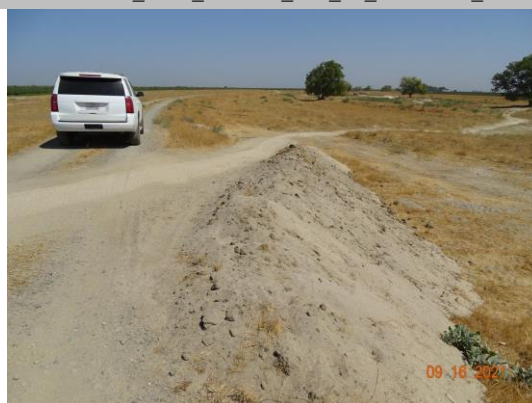
Photo 1 of 1 : FA\_2021\_NA0010\_131\_10\_20211006\_00013.jpg

LM Start	0.48	Rating **	M	Issue No.	10
LM End	0.48	Issue Type +	En	Location *	WS
Category	Earthen Levee			GPS Latitude/Longitude	
				Start	End
Item	Encroachments			37.040347 °	37.040347 °
				-120.439312 °	-120.439312 °
DWR ID	DWR_NA0010_13_f_2021_10				
Comment Code					
RA : Ramp					
Inspector Comment

View of unauthorized ramp on the waterside slope. (Fall 2021)

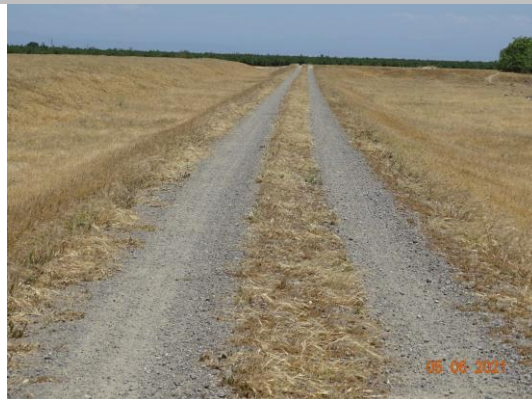
Photo 1 of 1 : FA\_2021\_NA0010\_131\_3\_20210830\_00001.jpg

LM Start	0.56	Rating **	M	Issue No.	3
LM End	0.70	Issue Type +	Ma	Location *	CR
Category	Earthen Levee			GPS Latitude/Longitude	
				Start	End
Item	Vegetation			37.041294 °	37.042745 °
				-120.438570 °	-120.436775 °
DWR ID	DWR_NA0010_13_s_2021_3				
Comment Code					
V9 : Keep the crown roadway free of vegetation.					
Inspector Comment

Looking upstream along the levee crown. (Spring 2021)

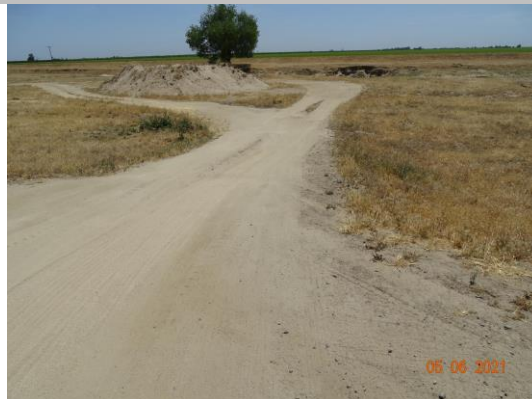
Photo 1 of 1 : FA\_2021\_NA0010\_131\_5\_20210830\_00003.jpg

LM Start	0.91	Rating **	M	Issue No.	5
LM End	0.91	Issue Type +	En	Location *	WS
Category	Earthen Levee			GPS Latitude/Longitude	
				Start	End
Item	Encroachments			37.044855 °	37.044855 °
				-120.434106 °	-120.434106 °
DWR ID	DWR_NA0010_13_s_2014_5				
Comment Code					
RA : Ramp					
Inspector Comment					
There is an unauthorized ramp on waterside slope.

Unauthorized ramp constructed on the waterside slope. (Spring 2021)

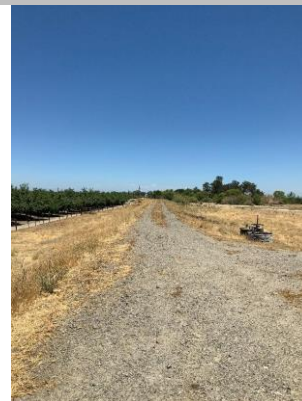
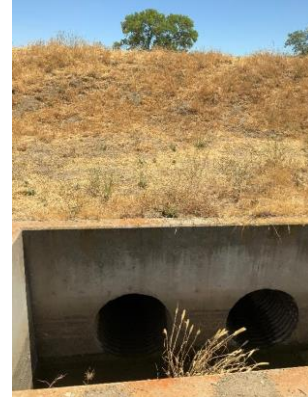
Comment Code						
Inspector Comment						
DS_ID:19727 FS_ID:69821 EP_NO: N/A Repair Type: Non-Urgent EVAL Issue: Limited Inspection/No UCIP Evaluation Crossing Status: Found UCIP Comments: 06/23/2021 The record remains Non-Urgent. Appears abandoned due to actuator missing on slidegate on the WS shoulder and if abandoned, should be done properly. Limited inspection of inlet and outlet due to standing water over concrete platforms surrounding pipe inlet/outlet, creating inability to inspect closely. No permit was found authorizing this encroachment. CVFPB will need to review crossing to determine owner. The UCIP inspection was completed with GEI staff, H.Dunn. (P.Espinoza – GEI)03/27/2014 Appears abandoned and if so should be done so properly. Pipe filled with soil on WS at outlet. Actuator missing from slide gate on WS shoulder. (W. Wylie - DWR UCIP) FIELD_STRUCT_DESC: [Rounder Irrigation Structure] 1 of 2: 36-inch corrugated metal gravity drainage pipe through the levee, 12.3 feet below the crown. Slide gate in a 48-inch corrugated metal pipe (CMP) riser on the waterside (WS) slope. 6-foot by 12-foot concrete distribution box on the landside (LS). 7-foot by 14-foot concrete outlet structure on the WS toe. [Additional Reference(s): DWR Levee Log, 2002 (HLM 1.14), listed as a 36-inch corrugated metal pipe (CMP). USACE San Joaquin O&M Manual, Unit 601 Part 1 (SJR601.1), 1967, (HLM 1.14), listed as a 36-inch CMP]. FS Date: 6/23/2021 1:08:00 PM

View of levee crown.

LS view: concrete inlet pipe on LS toe.

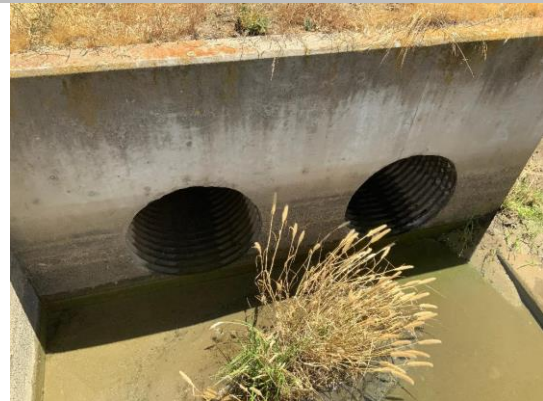
Photo 3 of 3 : UCIP\_FA\_2021\_69821\_103419.jpg

LS view: close up of concrete inlet pipe on LS toe.

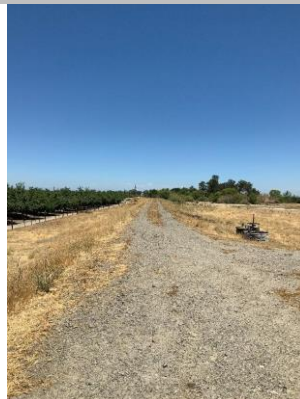
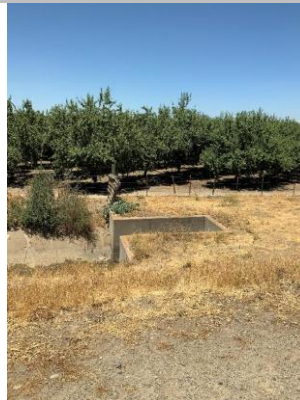
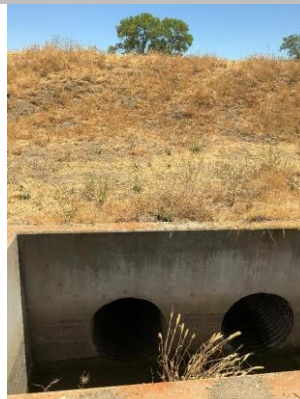
DS\_ID:19908  
FS\_ID:69820  
EP\_NO: N/A  
Repair Type: Non-Urgent  
EVAL Issue: Safety Issue  
Crossing Status: Found  
UCIP Comments: 06/23/2021 The record remains Non-Urgent. DWR DMP internal inspection has found pipe integrity issues. LOF of crossing is between 4.1 and 5. Crossing will be monitored until funding becomes available for rehabilitation. No lid on riser at WS shoulder, causing safety hazard. Limited inspection of both inlet and outlet due to standing water over concrete pads around the pipe inlet/out. Outlet also has metal grate over it, limiting ability to inspect pipe closely. No permit was found authorizing this encroachment. CVFPB will need to review crossing to determine owner. The UCIP inspection was completed with GEI staff, H.Dunn. (P.Espinoza – GEI)03/27/2014 No lid on riser at WS shoulder could be safety issue. (W. Wylie - DWR UCIP)  
FIELD\_STRUCT\_DESC: [Rounder Irrigation Structure] 2 of 2: 36-inch corrugated metal gravity drainage pipe through the levee, 12.3 feet below the crown. Slide gate in a 48-inch corrugated metal pipe (CMP) riser on the waterside (WS) slope. 6-foot by 12-foot concrete distribution box on the landside (LS). 7-foot by 14-foot concrete outlet structure on the WS toe. [Additional Reference(s): DWR Levee Log, 2002 (HLM 1.14), listed as a 36-inch corrugated metal pipe (CMP). USACE San Joaquin O&M Manual, Unit 601 Part 1 (SJR601.1), 1967, (HLM 1.14), listed as a 36-inch CMP].

View of levee crown.

LS view from levee crown.

LS view: Slope and headwall from toe.

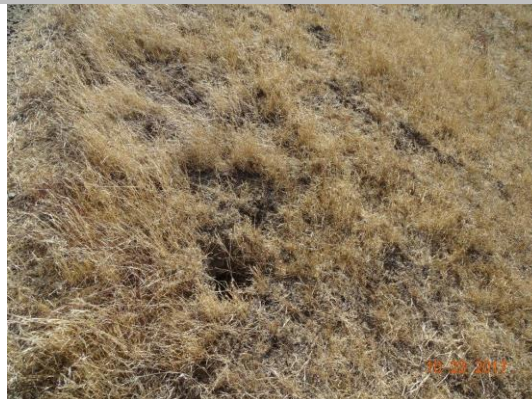
Photo 1 of 1 : FA\_2021\_NA0010\_132\_5\_20210830\_00002.jpg

LM Start	0.25	Rating **	A/W	Issue No.	5
LM End	0.25	Issue Type +	Ma	Location *	LS
Category	Earthen Levee			GPS Latitude/Longitude	
				Start	End
Item	Animal Control			37.035841 °	37.035841 °
				-120.439795 °	-120.439795 °
DWR ID	DWR_NA0010_14_f_2017_5				
Comment Code					
A3 : No rodents visible, but rodent burrows visible; need to backfill and compact or grout burrows.					
Inspector Comment

Looking at the landside slope.

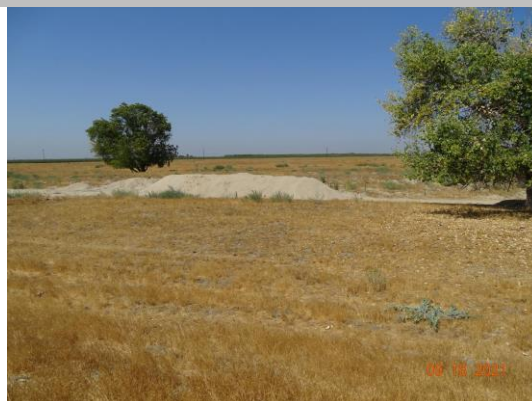
Photo 1 of 1 : FA\_2021\_NA0010\_132\_7\_20211006\_00010.jpg

LM Start	0.67	Rating **	U	Issue No.	7
LM End	0.67	Issue Type +	En	Location *	WS
Category	Rivers, Channels & Designated Floodways			GPS Latitude/Longitude	
				Start	End
Item	Encroachments			37.041266 °	37.041266 °
				-120.436700 °	-120.436700 °
DWR ID	DWR_NA0010_14_f_2021_7				
Comment Code					
Inspector Comment					
Landowner is storing material in the channel.

View of large amount of material being piled within the channel. (Fall 2021)

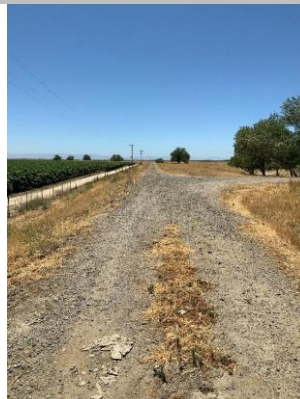
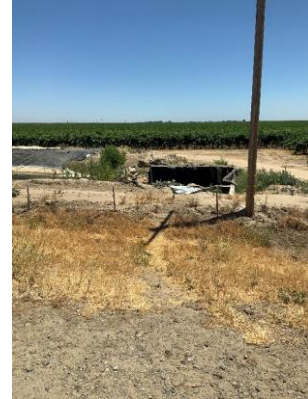
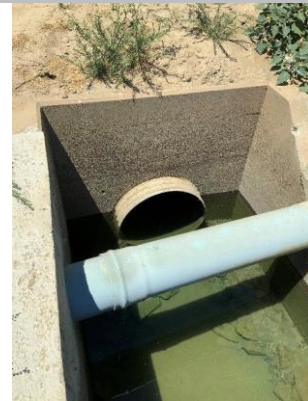
Comment Code						
Inspector Comment						
DS_ID:19909 FS_ID:69943 EP_NO: N/A Repair Type: Non-Urgent EVAL Issue: Safety Issue Crossing Status: Found UCIP Comments: 06/23/2021 The record remains Non-Urgent. DWR DMP internal inspection has found pipe integrity issues. LOF of crossing is between 4.1 and 5. Crossing will be monitored until funding becomes available for rehabilitation. CMP riser on WS slope is missing lid, causing a safety concern. Limited inspection of both inlet and outlet due to elevated standing water in concrete boxes surrounding inlet/outlet, limiting closeup inspection of pipe. No permit was found authorizing this encroachment. CVFPB will need to review crossing to determine owner. The UCIP inspection was completed with GEI staff, H.Dunn. (P.Espinoza – GEI)03/27/2014 Lid should be installed on CMP riser on WS slope, could be a safety hazard. Also dense vegetation limits the inspector's visibility to identify signs of pipe failure (leaks) along the slope. Recommend removing vegetation along pipe alignment to conduct proper inspection of structure. (O. Magana - DWR UCIP) FIELD_STRUCT_DESC: [Rounder Irrigation Structure] 36-inch corrugated metal gravity irrigation pipe through the levee, 10 feet below the crown. Slide gate in a 48-inch corrugated metal pipe (CMP) riser on the waterside (WS) slope. 6-foot by 7-foot concrete distribution box at the WS toe. Slots for wooden flashboards on the WS of the box. 7-foot by 9-foot concrete distribution box on the landside (LS), 20 feet from the toe. [Additional Reference(s): DWR Levee Log, 2002 (HLM 1.15), listed as a 36-inch corrugated metal pipe (CMP). USACE San Joaquin O&M Manual, Unit 601 Part 1 (SJR601.1), 1967, (HLM 1.15), listed as a 36-inch CMP]. FS Date: 6/23/2021

View of levee crown.

LS view from crown. Concrete headwall visible in background.

LS view: Concrete box and inlet pipe.

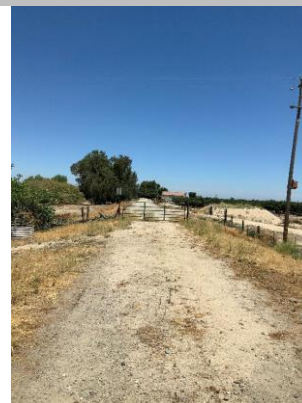
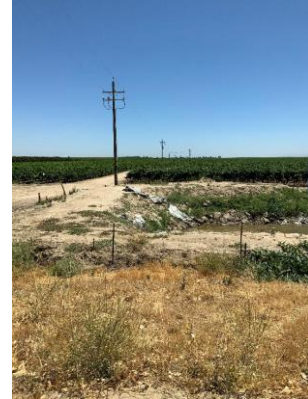
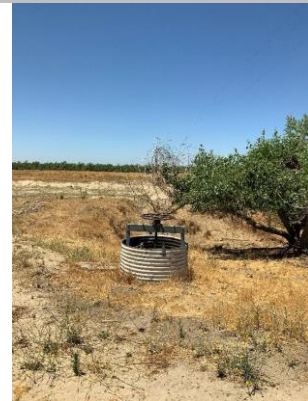
Comment Code						
Inspector Comment						
DS_ID:19910 FS_ID:69824 EP_NO: N/A Repair Type: Urgent EVAL Issue: Pipe Integrity Crossing Status: Indicator Found UCIP Comments: 06/23/2021 Record has been upgraded from No Action Needed to Urgent. DWR DMP internal inspection has found pipe integrity issues. LOF of crossing is between 5 and 6. Crossing will be monitored until funding becomes available to address the issues. Lid missing from CMP riser on WS slope, causing safety concern. LS not accessible; limited inspection due to barbed wire. No permit was found authorizing this encroachment. CVFPB will need to review crossing to determine owner. The UCIP inspection was completed with GEI staff, H.Dunn. (P.Espinoza – GEI) FIELD_STRUCT_DESC: 36-inch corrugated metal gravity drainage pipe through the levee, 9 feet below the crown. Slide gate in a 42-inch corrugated metal pipe (CMP) riser on the waterside (WS) slope. Concrete U-shaped headwall on the WS end. Pipe terminates into a concrete ditch on the landside (LS). [Additional Reference(s): DWR Levee Log, 2002 (HLM 1.26), listed as a 36-inch corrugated metal pipe (CMP). USACE San Joaquin O&M Manual, Unit 601 Part 1 (SJR601.1), 1967, (HLM 1.26), listed as a 36-inch CMP]. FS Date: 6/23/2021 2:07:00 PM

View from levee crown.

LS view: inlet assumed to be within irrigation structure off of toe.

WS view: slidegate in CMP riser.

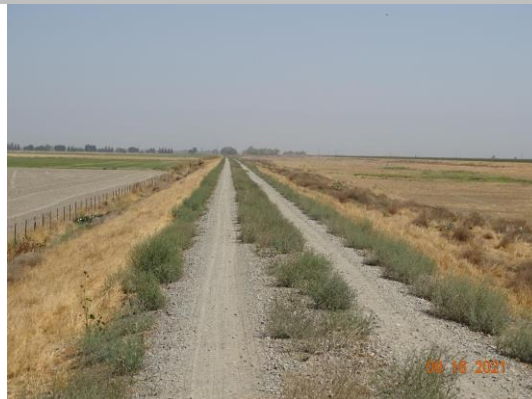
Photo 1 of 1 : FA\_2021\_NA0010\_133\_5\_20211006\_00010.jpg

LM Start	0.26	Rating **	M	Issue No.	5
LM End	0.55	Issue Type +	Ma	Location *	CR
Category	Earthen Levee			GPS Latitude/Longitude	
				Start	End
Item	Vegetation			36.996540 °	36.996536 °
				-120.405812 °	-120.400427 °
DWR ID	DWR_NA0010_15_f _ 2021_5				
Comment Code					
V9 : Keep the crown roadway free of vegetation.					
Inspector Comment

View of vegetation growing on the levee crown. (Fall 2021)

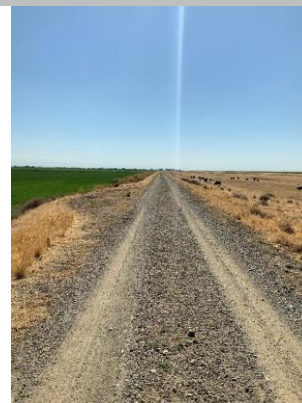
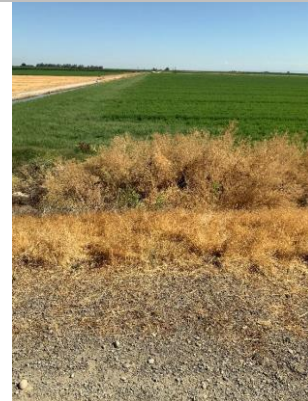
Comment Code						
Inspector Comment						
DS_ID:19911 FS_ID:69825 EP_NO: N/A Repair Type: Non-Urgent EVAL Issue: Limited Inspection/No UCIP Evaluation Crossing Status: Indicator Found UCIP Comments: 06/24/2021 The record has been upgraded from No Action Needed to Non-Urgent. Limited inspection of LS due to vegetation overgrowth; recommend removal. Water was actively flowing through WS pipe. No permit was found authorizing this encroachment. CVFPB will need to review crossing to determine owner. The UCIP inspection was completed with GEI staff, H.Dunn. (P.Espinoza – GEI) FIELD_STRUCT_DESC: 30-inch by 30-inch square reinforced concrete box gravity drainage culvert through the levee, 10.1 feet below the crown. Flap gate on the waterside (WS) end. Concrete headwall on the landside (LS) end. Concrete U-shaped headwall on the WS end. [Additional Reference(s): DWR Levee Log, 2002 (HLM 0.49), listed as a 30-inch square reinforced concrete box culvert (RCBC). USACE San Joaquin O&M Manual, Unit 601 Part 1 (SJR601.1), 1967, (HLM 0.48), listed as a 2.5-feet by 2.5-feet RCBC]. FS Date: 6/24/2021 2:52:00 PM

view of levee crown.

LS view: concrete wall and entrance to pipe from toe. View of slope in background.

WS view: slope from crown.

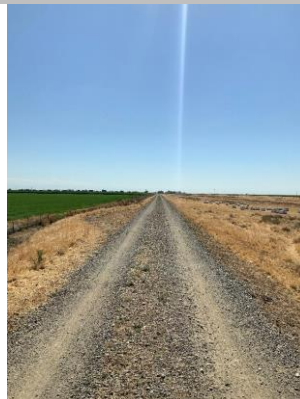
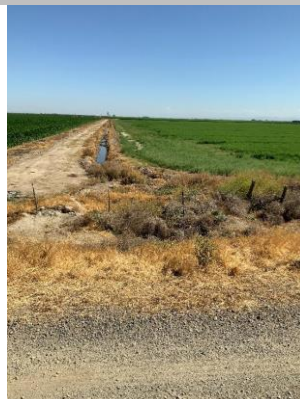
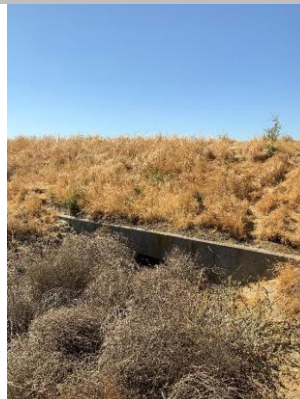
Comment Code						
Inspector Comment						
DS_ID:19912 FS_ID:69727 EP_NO: N/A Repair Type: Non-Urgent EVAL Issue: Limited Inspection/No UCIP Evaluation Crossing Status: Found UCIP Comments: 06/24/2021 The record remains Non-Urgent. Limited inspection of LS pipe due to vegetation overgrowth; recommend removal. No permit was found authorizing this encroachment. CVFPB will need to review crossing to determine owner. The UCIP inspection was completed with GEI staff, H.Dunn. (P.Espinoza – GEI)  03/27/2014 Dense vegetation limits the inspector's visibility to identify signs of pipe failure (leaks) along the landward slope. Recommend removing vegetation along pipe alignment to conduct proper inspection of structure. (W. Wylie - DWR UCIP) FIELD_STRUCT_DESC: 30-inch by 30-inch square reinforced concrete box gravity drainage culvert through the levee, 8.5 feet below the crown. Flap gate on the waterside (WS) end. Concrete headwall on the landside (LS) end. Concrete U-shaped headwall on the WS end. [Additional Reference(s): DWR Levee Log, 2002 (HLM 1.01), listed as a 30-inch square reinforced concrete box culvert (RCBC). USACE San Joaquin O&M Manual, Unit 601 Part 1 (SJR601.1), 1967, (HLM 1.01), listed as a 2.5-feet by 2.5-feet RCBC]. FS Date: 6/24/2021 3:18:00 PM

view of levee crown

LS view: toe from levee crown

LS view: concrete headwall on toe.

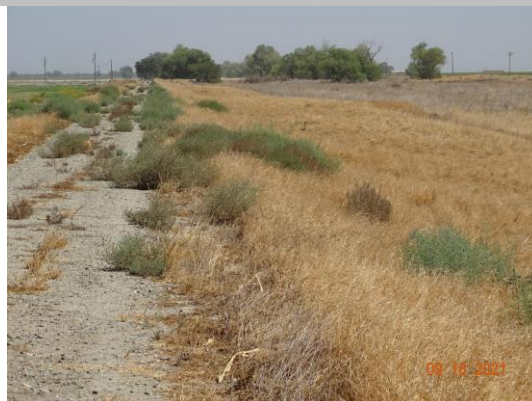
Photo 1 of 1 : FA\_2021\_NA0010\_133\_7\_20211006\_00011.jpg

LM Start	1.53	Rating **	M	Issue No.	7
LM End	1.97	Issue Type +	Ma	Location *	WS
Category	Earthen Levee			GPS Latitude/Longitude	
				Start	End
Item	Vegetation			36.996557 °	36.996575 °
				-120.382756 °	-120.374745 °
DWR ID	DWR_NA0010_15_f_2021_7				
Comment Code					
V1 : Control annual grass and weeds on the levee slopes and easements.					
Inspector Comment

Looking upstream along the waterside slope. (Fall 2021)

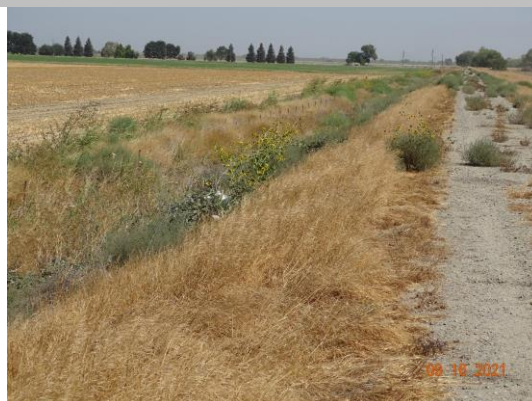
Photo 1 of 1 : FA\_2021\_NA0010\_133\_6\_20211006\_00012.jpg

LM Start	1.53	Rating **	M	Issue No.	6
LM End	1.99	Issue Type +	Ma	Location *	LS
Category	Earthen Levee			GPS Latitude/Longitude	
				Start	End
Item	Vegetation			36.996555 °	36.996578 °
				-120.382755 °	-120.374496 °
DWR ID	DWR_NA0010_15_f_2021_6				
Comment Code					
V1 : Control annual grass and weeds on the levee slopes and easements.					
Inspector Comment

View of the landside slope looking upstream. (Fall 2021)

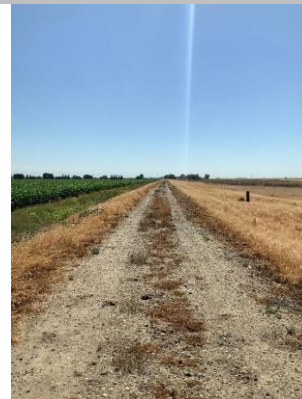
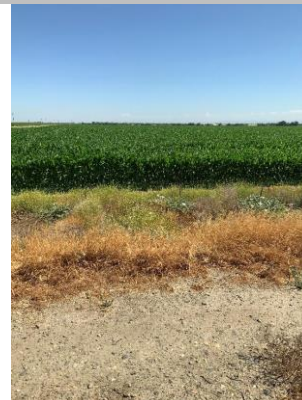
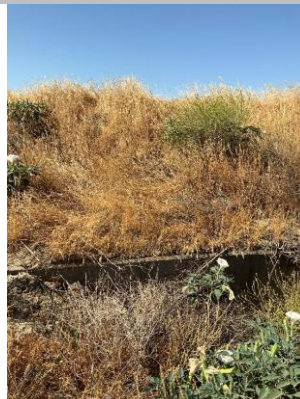
Comment Code					
Inspector Comment					
DS_ID:19913 FS_ID:69728 EP_NO: N/A Repair Type: Non-Urgent EVAL Issue: Limited Inspection/No UCIP Evaluation Crossing Status: Found UCIP Comments: 06/24/2021 The record remains Non-Urgent. Limited inspection of LS pipe due to vegetation overgrowth; recommend removal. Note that wooden board is holding flapgate closed on WS; recommend removing before flood season to allow for flow. No permit was found authorizing this encroachment. CVFPB will need to review crossing to determine owner. The UCIP inspection was completed with GEI staff, H.Dunn. (P.Espinoza – GEI) 03/27/2014 Excessive vegetation at inlet on LS toe. (W. Wylie - DWR UCIP) FIELD_STRUCT_DESC: 30-inch by 30-inch square reinforced concrete box gravity drainage culvert through the levee, 8.9 feet below the crown. Flap gate on the waterside (WS) end. Concrete headwall on the landside (LS) end. Concrete U-shaped headwall on the WS end. [Additional Reference(s): DWR Levee Log, 2002 (HLM 1.54), listed as a 30-inch square reinforced concrete box culvert (RCBC). USACE San Joaquin O&M Manual, Unit 601 Part 1 (SJR601.1), 1967, (HLM 1.53), listed as a 2.5-feet by 2.5-feet RCBC]. FS Date: 6/24/2021 3:47:00 PM

view of levee crown.

LS view of toe from levee crown.

LS view: concrete headwall from toe.

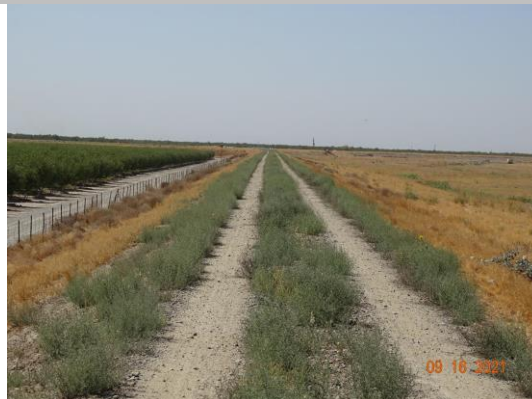
Photo 1 of 1 : FA\_2021\_NA0010\_134\_7\_20211006\_00007.jpg

LM Start	0.01	Rating **	M	Issue No.	7
LM End	0.37	Issue Type +	Ma	Location *	CR
Category	Earthen Levee			GPS Latitude/Longitude	
				Start	End
Item	Vegetation			36.995399 °	36.995438 °
				-120.408819 °	-120.402279 °
DWR ID	DWR_NA0010_16_f _ 2021_7				
Comment Code					
V9 : Keep the crown roadway free of vegetation.					
Inspector Comment

Looking downstream along the levee crown. (Fall 2021)

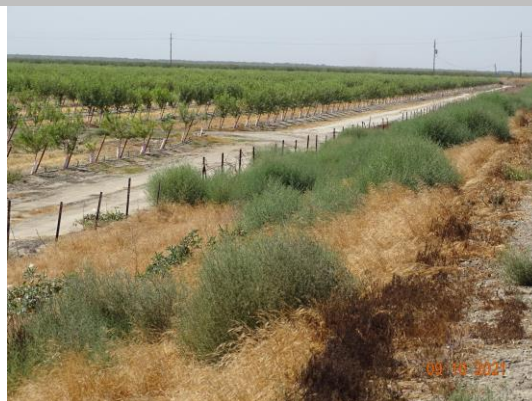
Photo 1 of 1 : FA\_2021\_NA0010\_134\_6\_20211006\_00008.jpg

LM Start	1.41	Rating **	M	Issue No.	6
LM End	1.94	Issue Type +	Ma	Location *	LS
Category	Earthen Levee			GPS Latitude/Longitude	
				Start	End
Item	Vegetation			36.995474 °	36.995497 °
				-120.383501 °	-120.373836 °
DWR ID	DWR_NA0010_16_f_2021_6				
Comment Code					
V1 : Control annual grass and weeds on the levee slopes and easements.					
Inspector Comment

View of vegetation growing along the landside slope. (Fall 2021)

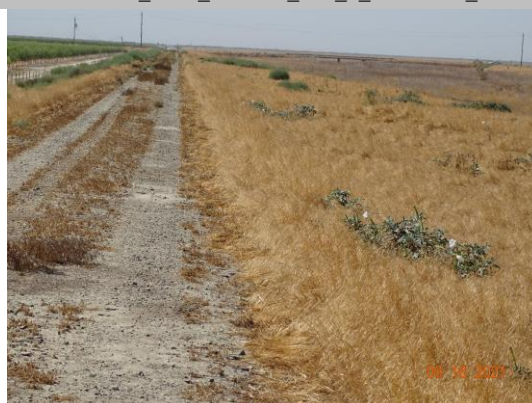
Photo 1 of 1 : FA\_2021\_NA0010\_134\_5\_20211006\_00009.jpg

LM Start	1.41	Rating **	M	Issue No.	5
LM End	1.94	Issue Type +	Ma	Location *	WS
Category	Earthen Levee			GPS Latitude/Longitude	
				Start	End
Item	Vegetation			36.995474 °	36.995496 °
				-120.383501 °	-120.373834 °
DWR ID	DWR_NA0010_16_f_2021_5				
Comment Code					
V1 : Control annual grass and weeds on the levee slopes and easements.					
Inspector Comment

Looking downstream along the waterside slope. (Fall 2021)

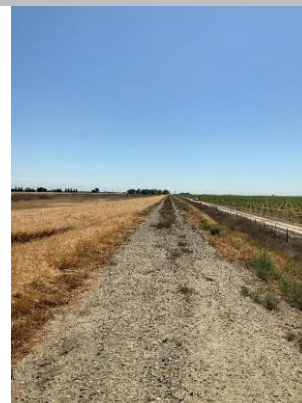
Photo 1 of 3 : UCIP\_FA\_2021\_69769\_103847.jpg

Comment Code						
Inspector Comment						
DS_ID:19915 FS_ID:69769 EP_NO: N/A Repair Type: Non-Urgent EVAL Issue: Limited Inspection/No UCIP Evaluation Crossing Status: Found UCIP Comments: 06/24/2021 The record remains Non-Urgent. Limited inspection on LS and WS due to vegetation overgrowth, recommend removal. No permit was found authorizing this encroachment. CVFPB will need to review crossing to determine owner. The UCIP inspection was completed with GEI staff, H.Dunn. (P.Espinoza – GEI)  04/01/2014 Dense vegetation buildup at landside toe--recommend clearing. (W. Wylie - DWR UCIP) FIELD_STRUCT_DESC: 30-inch by 30-inch square reinforced concrete box gravity drainage culvert through the levee, 8.5 feet below the crown. Two concrete cutoff walls. Flap gate on the waterside (WS) end. Concrete headwall on the landside (LS) end. Concrete U-shaped headwall on the WS end. [Additional Reference(s): DWR Levee Log, 2002 (HLM 1.46), listed as a 30-inch square reinforced concrete box culvert (RCBC). USACE San Joaquin O&M Manual, Unit 601 Part 1 (SJR601.1), 1967, (HLM 1.46), listed as a 2.5-feet by 2.5-feet RCBC]. FS Date: 6/24/2021 11:09:00 AM

View of levee crown.

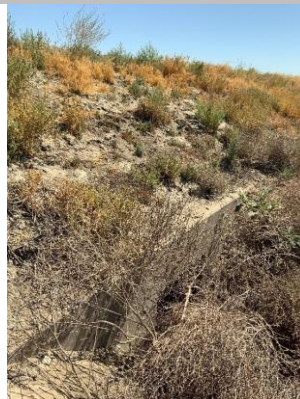
Photo 2 of 3 : UCIP\_FA\_2021\_69769\_103851.jpg

LS view: Slope and concrete headwall at inlet, covered by heavy vegetation.

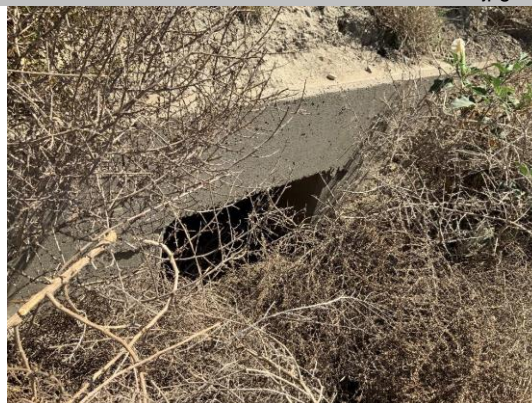
Photo 3 of 3 : UCIP\_FA\_2021\_69769\_103852.jpg

LS view: close up of concrete headwall at inlet.

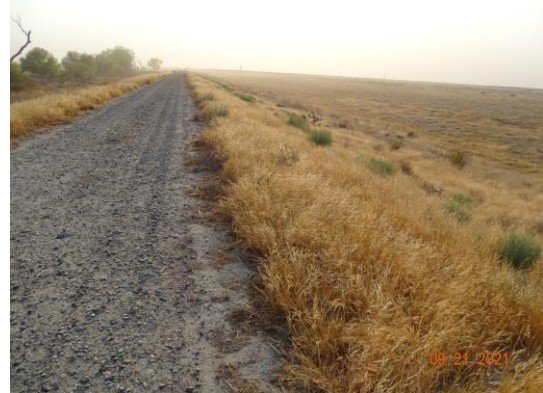
Photo 1 of 1 : FA\_2021\_NA0010\_135\_16\_20211006\_00037.jpg

LM Start	0.18	Rating **	M	Issue No.	16
LM End	4.28	Issue Type +	Ma	Location *	WS
Category	Earthen Levee			GPS Latitude/Longitude	
				Start	End
Item	Vegetation			36.976444 °	36.929046 °
				-120.371430 °	-120.338630 °
DWR ID	DWR_NA0010_17_f_2021_16				
Comment Code					
V1 : Control annual grass and weeds on the levee slopes and easements.					
Inspector Comment

View of vegetation on the waterside slope. (Fall 2021)

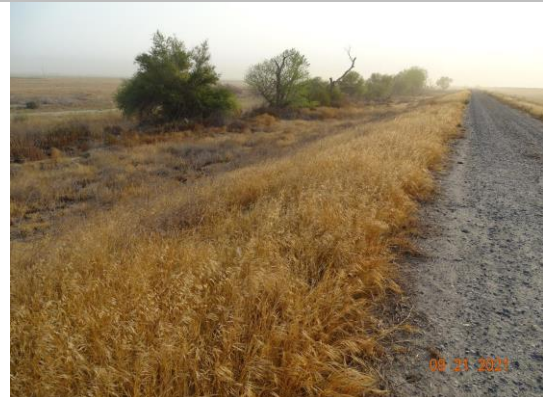
Photo 1 of 1 : FA\_2021\_NA0010\_135\_15\_20211006\_00038.jpg

LM Start	0.18	Rating **	M	Issue No.	15
LM End	4.26	Issue Type +	Ma	Location *	LS
Category	Earthen Levee			GPS Latitude/Longitude	
				Start	End
Item	Vegetation			36.976447 °	36.929251 °
				-120.371424 °	-120.338705 °
DWR ID	DWR_NA0010_17_f _ 2021_15				
Comment Code					
V1 : Control annual grass and weeds on the levee slopes and easements.					
Inspector Comment

View of vegetation along the landside slope. (Fall 2021)

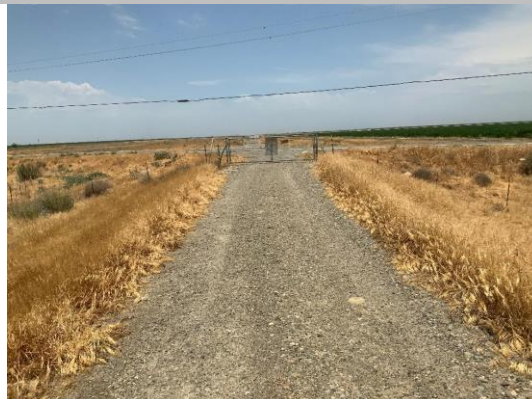
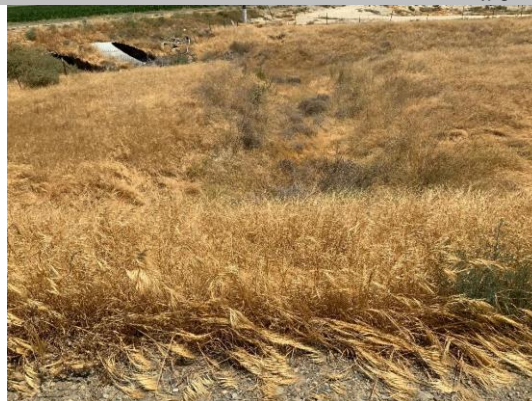
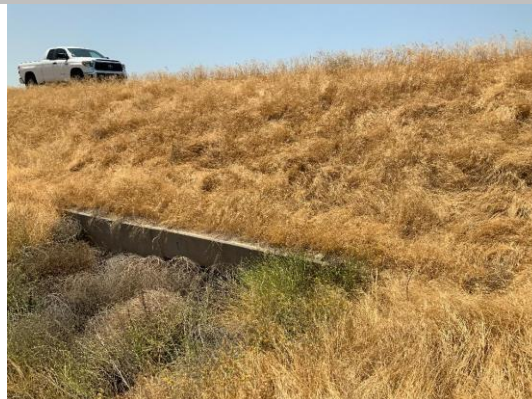
DS\_ID:19916  
FS\_ID:68828  
EP\_NO: N/A  
Repair Type: Non-Urgent  
EVAL Issue: Limited Inspection/No UCIP Evaluation  
Crossing Status: Found  
UCIP Comments: 07/13/2021 The record remains Non-Urgent. Limited inspection due to tumbleweeds blocking LS pipe inlet, recommend removal. No permit was found authorizing this encroachment. CVFPB will need to review crossing to determine owner. The UCIP inspection was completed with GEI staff, P. Espinoza. (H. Dunn – GEI)

04/01/2014 Dense vegetation limits the inspector's visibility to identify signs of pipe failure (leaks) along the landward slope. Recommend removing vegetation along pipe alignment to conduct proper inspection of structure. (W. Wylie - DWR UCIP)  
FIELD\_STRUCT\_DESC: 48-inch by 60-inch reinforced concrete box gravity drainage culvert through the levee, 14.6 feet below the crown. Flap gate on the waterside (WS) end. Concrete headwall on the landside (LS) end. Concrete U-shaped headwall on the WS end.  
[Additional Reference(s): DWR Levee Log, 2002 (HLM 2.58), listed as a 48-inch by 60-inch reinforced concrete box culvert (RCBC). USACE San Joaquin O&M Manual, Unit 601 Part 1 (SJR601.1), 1967, (HLM 2.58), listed as a 5-feet by 4-feet RCBC].  
FS Date: 7/19/2021
