## Flood Control Project Maintenance Levee Inspections

### Fall 2021 Levee Maintenance Deficiency Summary Report

#### San Joaquin River Basin

NA0010 Lower San Joaquin Levee District	Overall LMA Rating	Total LMA Miles							
	U	191.27							
Rated Item	Maintenance Deficiency				Enforcement		Design & System Obsolescence		
	M Miles	U Miles	M + 4U Miles	Threshold %	M Miles	U Miles	M Miles	U Miles	
<i>Earthen Levee</i>									
Vegetation	47.00	9.57	85.28	44.59%					
Trim / Thin Trees	0.10		0.10	0.05%					
Encroachments	0.23	0.02	0.31	0.16%	9.29	0.59			
Animal Control	7.67	2.19	16.43	8.59%					
Slope Stability	0.05	0.01	0.09	0.05%					
Erosion / Bank Caving	0.13	0.81	3.37	1.76%					
Crown Surface / Depressions / Rutting	0.01		0.01	0.01%					
Repair Gates	0.02	0.02	0.10	0.05%					
<i>Rivers, Channels &amp; Designated Floodways</i>									
Encroachments					0.01	0.01			
<i>Supplemental</i>									
DWR Erosion Survey	0.12	0.17	0.80	0.42%					
DWR UCIP Field Study					1.29	0.05			
DWR UCIP LMA Responsibility									
<i>LMA Totals:</i>	55.33	12.79	106.49	55.67%	10.59	0.65	0.00	0.00

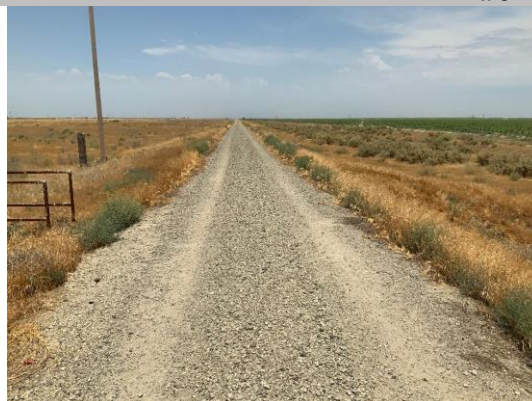
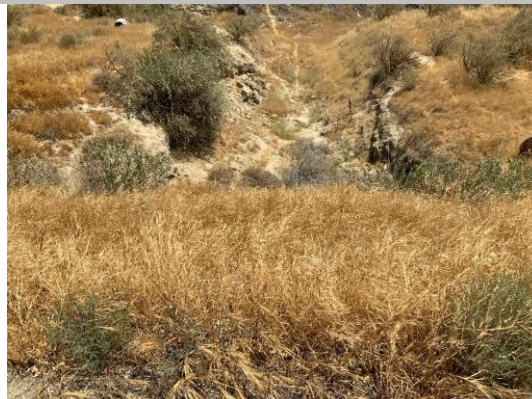
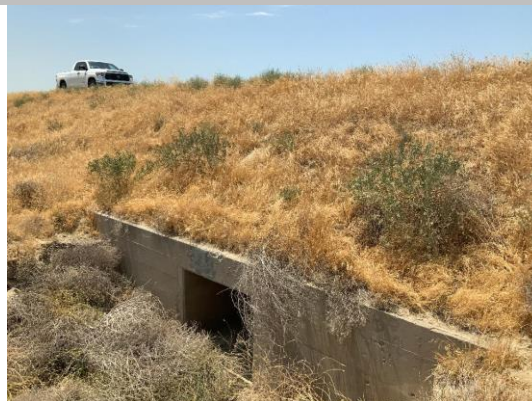
DS\_ID:19921  
 FS\_ID:68516  
 EP\_NO: 13587  
 Repair Type: Non-Urgent  
 EVAL Issue: Maintenance Compliance Issue  
 Crossing Status: Found  
 UCIP Comments: 07/13/2021 The record has been upgraded from No Action Needed to Non-Urgent. Dense vegetation over the WS gate, recommend clearing out for better flow during flood season. Some minor vegetation over LS pipe inlet, recommend removal. The UCIP inspection was completed with GEI staff, P. Espinoza. (H. Dunn – GEI)  
 FIELD\_STRUCT\_DESC: 48-inch by 60-inch reinforced concrete box gravity drainage culvert through the levee, 14.6 feet below the crown. Concrete U-shaped headwall on the waterside (WS) end. 36-inch weir structure on the WS. Combination flap gate and slide gate on the WS toe. Steel walkway to slide gate actuator on the WS shoulder. (Plans to construct a 3.281-foot-high weir and attach a cable operated flap valve to an existing 48-inch by 60-inch culvert authorized under Permit No. 13587, 1983 - Clark Brothers Farming, Arroyo Ranch). [Additional Reference(s): DWR Levee Log, 2002 (HLM 4.68), listed as a 48-inch by 60-inch reinforced concrete box culvert (RCBC). USACE San Joaquin O&M Manual, Unit 601 Part 1 (SJR601.1), 1967, (HLM 4.69), listed as a 5-feet by 4-feet RCBC].

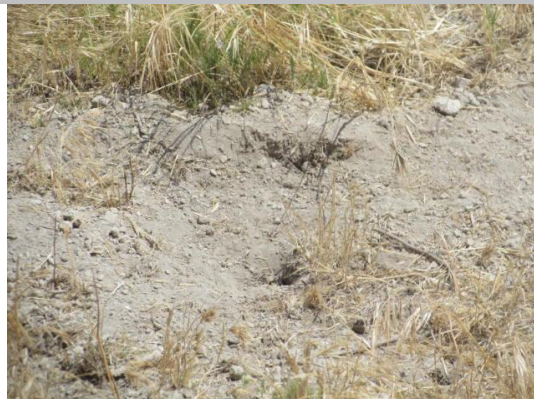
Photo 1 of 1 : FA\_2021\_NA0010\_135\_5\_20210830\_00003.jpg

LM Start	7.27	Rating **	M	Issue No.	5
LM End	7.38	Issue Type +	Ma	Location *	LS
Category	Earthen Levee			GPS Latitude/Longitude	
				Start	End
Item	Animal Control			36.887852 °	36.886388 °
				-120.321668 °	-120.320950 °
DWR ID	DWR_NA0010_17_s_2012_5				
Comment Code					
A3 : No rodents visible, but rodent burrows visible; need to backfill and compact or grout burrows.					
Inspector Comment					
Several rodent holes are identified within this reach.

Looking at typical view of rodent holes on landward slope.

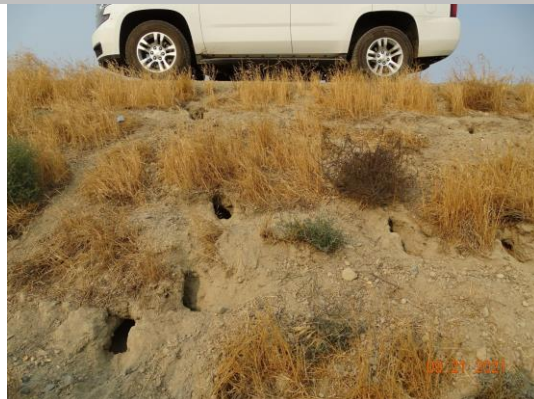
Photo 1 of 1 : FA\_2021\_NA0010\_135\_18\_20211006\_00040.jpg

LM Start	7.74	Rating **	U	Issue No.	18
LM End	7.74	Issue Type +	Ma	Location *	LS
Category	Earthen Levee			GPS Latitude/Longitude	
				Start	End
Item	Animal Control			36.881470 °	36.881470 °
				-120.318961 °	-120.318961 °
DWR ID	DWR_NA0010_17_f_2021_18				
Comment Code					
A3 : No rodents visible, but rodent burrows visible; need to backfill and compact or grout burrows.					
Inspector Comment

Looking up the landside slope at several rodent holes. (Fall 2021)

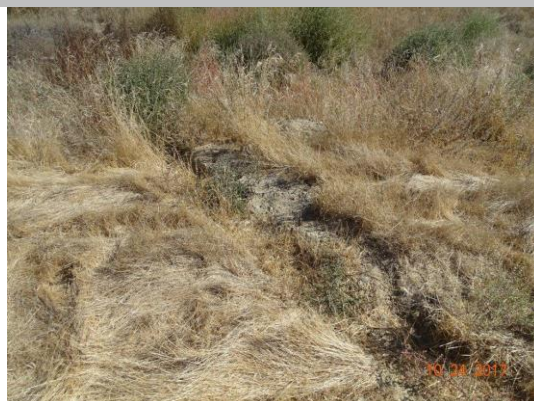
Photo 1 of 1 : FA\_2021\_NA0010\_135\_24\_20210830\_00007.jpg

LM Start	8.15	Rating **	M	Issue No.	24
LM End	8.15	Issue Type +	Ma	Location *	LS
Category	Earthen Levee			GPS Latitude/Longitude	
				Start	End
Item	Animal Control			36.875525 °	36.875525 °
				-120.317788 °	-120.317788 °
DWR ID	DWR_NA0010_17_f_2017_24				
Comment Code					
A3 : No rodents visible, but rodent burrows visible; need to backfill and compact or grout burrows.					
Inspector Comment					
Rodent holes are on the landside and crown of levee. Rodent holes have caused some erosion on the landside slope.

Looking east at the landside slope.

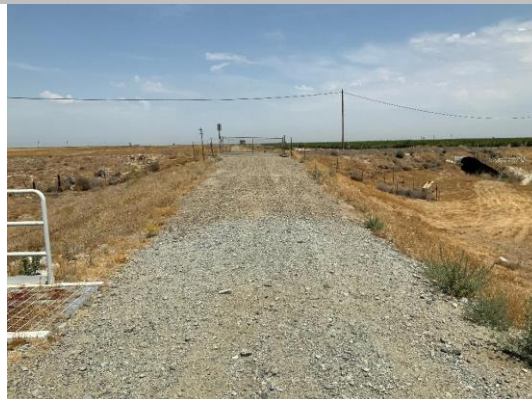
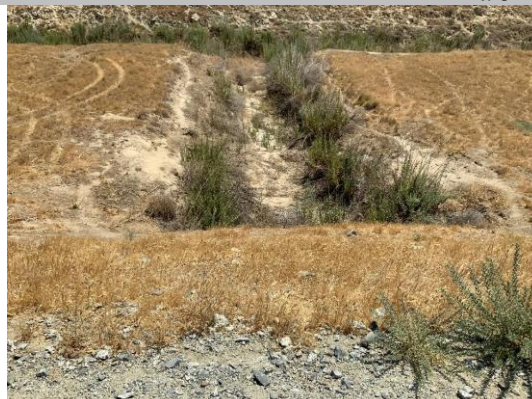
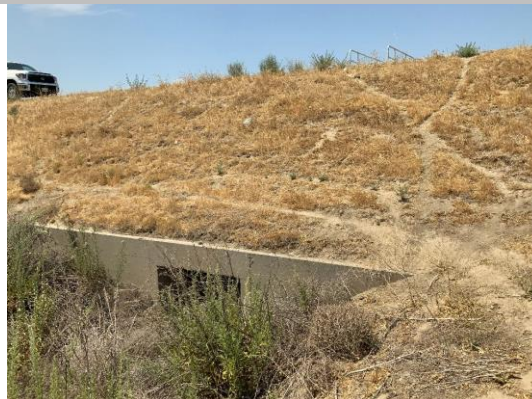
Comment Code					
Inspector Comment					
DS_ID:19922 FS_ID:68829 EP_NO: N/A Repair Type: Non-Urgent EVAL Issue: Limited Inspection/No UCIP Evaluation Crossing Status: Found UCIP Comments: 07/13/2021 The record has been upgraded from No Action Needed to Non-Urgent. Limited inspection due to dense tumbleweeds over LS pipe inlet, recommend removal. No permit was found authorizing this encroachment. CVFPB will need to review crossing to determine owner. The UCIP inspection was completed with GEI staff, P. Espinoza. (H. Dunn – GEI) FIELD_STRUCT_DESC: 48-inch by 60-inch reinforced concrete box gravity drainage culvert through the levee, 16.5 feet below the crown. Flap gate on the waterside (WS) end. Concrete headwall on the landside (LS) end. Concrete U-shaped headwall on the WS end. [Additional Reference(s): DWR Levee Log, 2002 (HLM 8.38), listed as a 48-inch by 60-inch reinforced concrete box culvert (RCBC). USACE San Joaquin O&M Manual, Unit 601 Part 1 (SJR601.1), 1967, (HLM 8.38), listed as a 5-feet by 4-feet RCBC]. FS Date: 7/19/2021

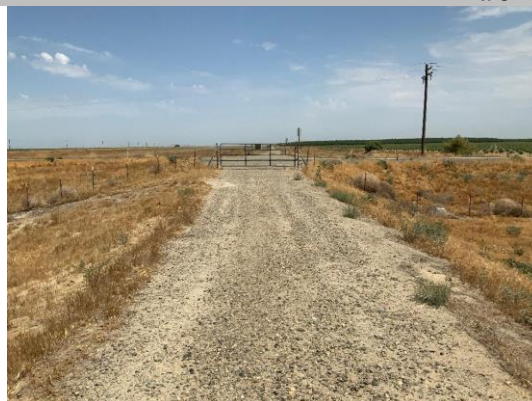
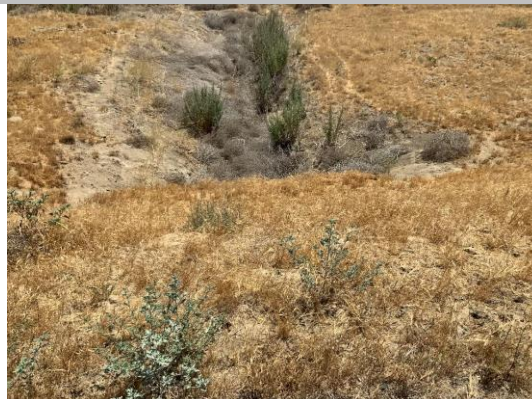
DS\_ID:19917  
FS\_ID:68830  
EP\_NO: N/A  
Repair Type: Non-Urgent  
EVAL Issue: Limited Inspection/No UCIP Evaluation  
Crossing Status: Found  
UCIP Comments: 07/13/2021 The record remains Non-Urgent. Limited inspection due to dense tumbleweeds over LS pipe inlet, recommend removal. No permit was found authorizing this encroachment. CVFPB will need to review crossing to determine owner. The UCIP inspection was completed with GEI staff, P. Espinoza. (H. Dunn – GEI)

04/01/2014 Dense vegetation limits the inspector's visibility to identify signs of pipe failure (leaks) along the landward slope. Recommend removing vegetation along pipe alignment to conduct proper inspection of structure. (W. Wylie - DWR UCIP)

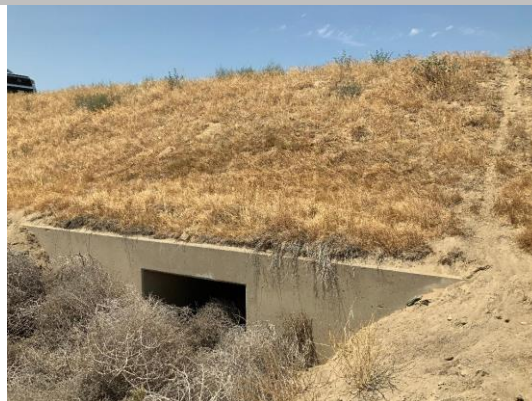
Photo 3 of 3 : UCIP\_FA\_2021\_68830\_102433.jpg

LS view: Headwall and slope from toe.

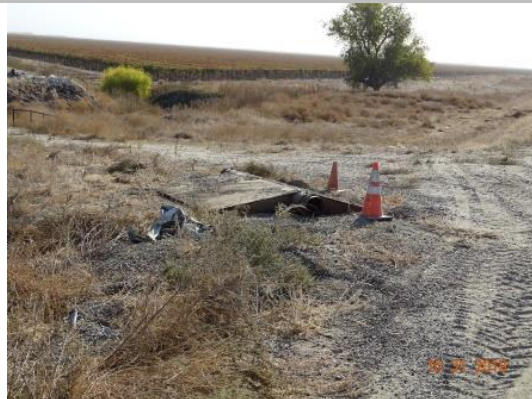
Photo 1 of 1 : FA\_2021\_NA0010\_135\_35\_20210830\_00008.jpg

LM Start	11.03	Rating **	A/W	Issue No.	35
LM End	11.03	Issue Type +	En	Location *	CR
Category	Earthen Levee			GPS Latitude/Longitude	
				Start	End
Item	Encroachments			36.836724 °	36.836724 °
				-120.305328 °	-120.305328 °
DWR ID	DWR_NA0010_17_f_2018_35				
Comment Code					
PI : Pipe					
Inspector Comment					
Temporary pipe and ramp were moved off the levee crown in Fall 2019 and are currently being stored on the waterside slope.

View of ramp and temporary pipe material left on the waterside slope.  
(Fall 2019)

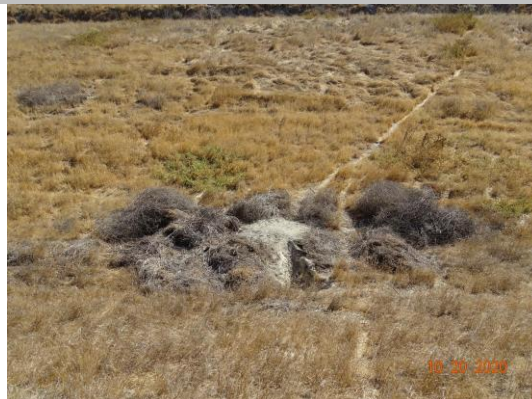
Photo 1 of 1 : FA\_2021\_NA0010\_135\_39\_20210830\_00009.jpg

LM Start	12.17	Rating **	U	Issue No.	39
LM End	12.17	Issue Type +	Ma	Location *	LS
Category	Earthen Levee			GPS Latitude/Longitude	
				Start	End
Item	Animal Control			36.822818 °	36.822818 °
				-120.299680 °	-120.299680 °
DWR ID	DWR_NA0010_17_f _ 2018_39				
Comment Code					
A3 : No rodents visible, but rodent burrows visible; need to backfill and compact or grout burrows.					
Inspector Comment					
A large hole is on the landside toe.

Large rodent hole at toe of levee. (Fall 2020)

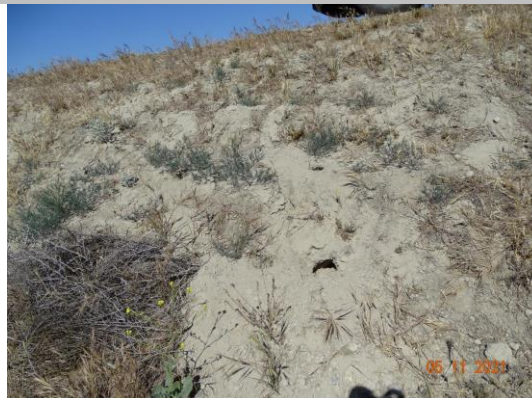
Photo 1 of 1 : FA\_2021\_NA0010\_135\_3\_20210830\_00001.jpg

LM Start	12.28	Rating **	M	Issue No.	3
LM End	12.32	Issue Type +	Ma	Location *	LS
Category	Earthen Levee			GPS Latitude/Longitude	
				Start	End
Item	Animal Control			36.821368 °	36.820843 °
				-120.300283 °	-120.300469 °
DWR ID	DWR_NA0010_17_s_2014_3				
Comment Code					
A3 : No rodents visible, but rodent burrows visible; need to backfill and compact or grout burrows.					
Inspector Comment

View of multiple rodent holes in the landside slope. (Spring 2021)

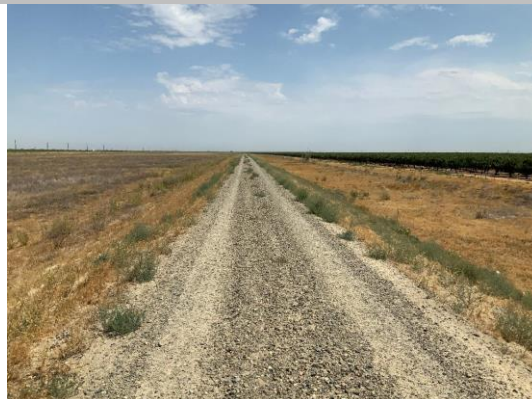
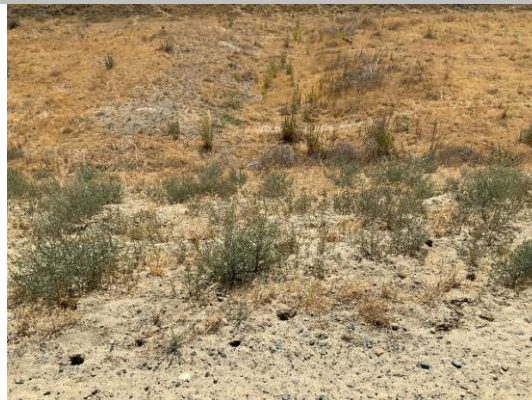
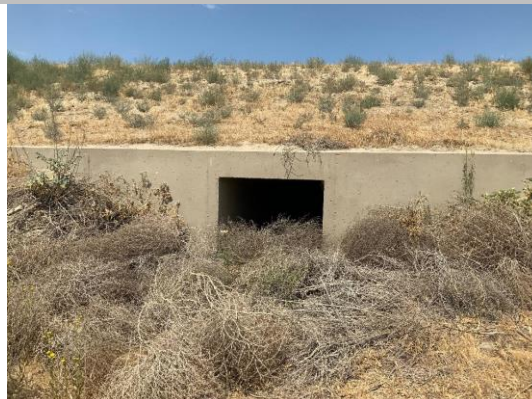
DS\_ID:19918  
FS\_ID:68831  
EP\_NO: N/A  
Repair Type: Non-Urgent  
EVAL Issue: Limited Inspection/No UCIP Evaluation  
Crossing Status: Found  
UCIP Comments: 07/13/2021 The record remains Non-Urgent. WS flapgate has plank holding it shut, remove before flood season. Limited inspection due to dense tumbleweeds covering LS pipe inlet, recommend removal. No permit was found authorizing this encroachment. CVFPB will need to review crossing to determine owner. The UCIP inspection was completed with GEI staff, P. Espinoza. (H. Dunn – GEI) 04/01/2014 Some vegetation buildup at inlet-- recommend clearing. (W. Wylie - DWR UCIP)  
FIELD\_STRUCT\_DESC: 48-inch by 60-inch reinforced concrete box gravity drainage culvert through the levee, 15.3 feet below the crown. Flap gate on the waterside (WS) end. Concrete headwall on the landside (LS) end. Concrete U-shaped headwall on the WS end.  
[Additional Reference(s): DWR Levee Log, 2002 (HLM 13.29), listed as a 48-inch by 60-inch reinforced concrete box culvert (RCBC). USACE San Joaquin O&M Manual, Unit 601 Part 1 (SJR601.1), 1967, (HLM 13.30), listed as a 5-feet by 4-feet RCBC].

LS view: Headwall visible at toe from crown.

LS view: Headwall and slope from toe.

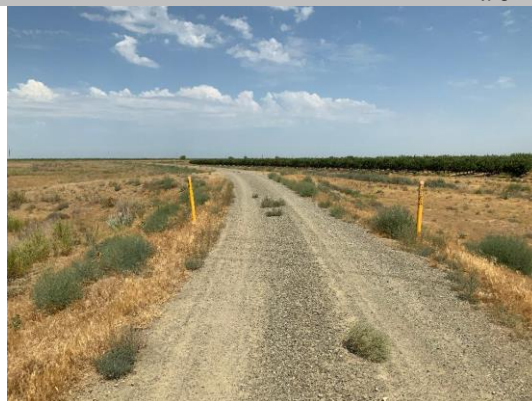
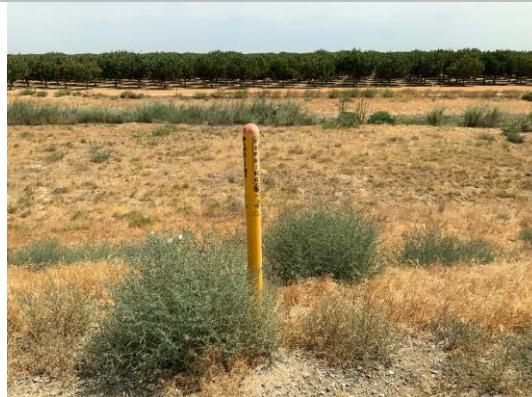
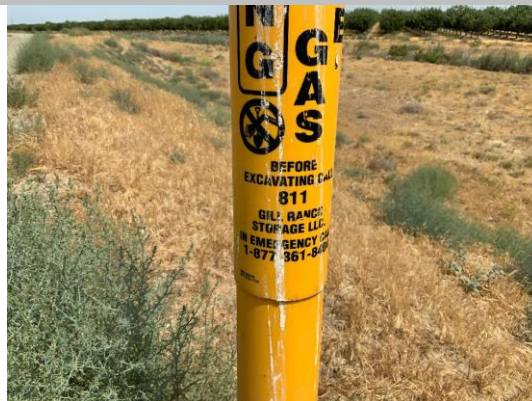
DS\_ID:24850  
 FS\_ID:68519  
 EP\_NO: N/A  
 Repair Type: Non-Urgent  
 EVAL Issue: Safety Issue  
 Crossing Status: Indicator Found  
 UCIP Comments: 07/13/2021 The record remains Non-Urgent. As a safety measure, need to coordinate with owner to determine status of line and to obtain maintenance and inspection records to confirm integrity of line through the levee. No permit was found authorizing this encroachment. CVFPB will need to review crossing to determine owner. The UCIP inspection was completed with GEI staff, P. Espinoza. (H. Dunn – GEI) 04/01/2014 No permit identified for this crossing. (W. Wylie - DWR UCIP)  
 FIELD\_STRUCT\_DESC: Natural gas pipeline of an unknown size or material through the levee, at an unknown depth. Gas line markers on both shoulders.  
 FS Date: 7/19/2021

LS view: Marker visible off crown.

LS view: Closeup of contact information on marker.

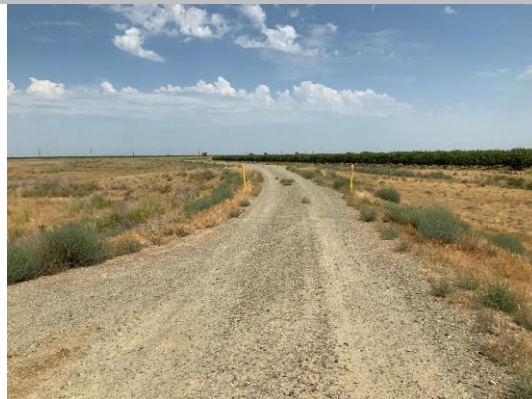
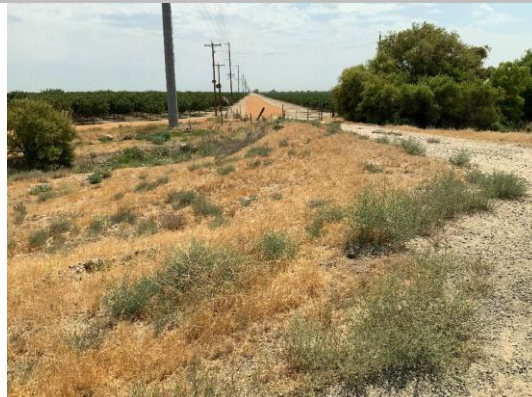
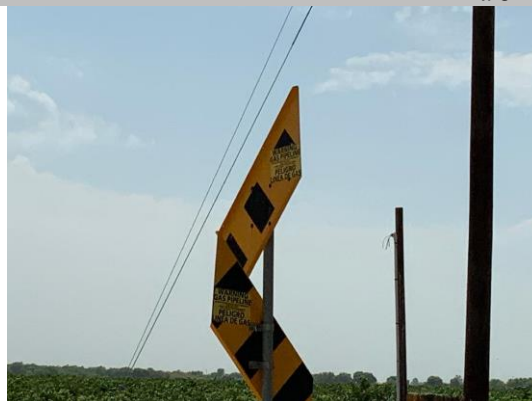
Comment Code					
Inspector Comment					
DS_ID:19562 FS_ID:68520 EP_NO: 18568 Repair Type: Non-Urgent EVAL Issue: Safety Issue Crossing Status: Indicator Found UCIP Comments: 07/19/2021 The record remains Non-Urgent. As a safety measure, need to coordinate with owner to determine status of line and to obtain maintenance and inspection records to confirm integrity of line through the levee. LS marker visible, but no WS marker. The UCIP inspection was completed with GEI staff, P. Espinoza. (H. Dunn – GEI)7/20/2016 Marker visible on LS. WS marker missing. (O. Magana - DWR UCIP)4/01/2014 Need to contact owner to confirm and obtain status of crossing. Markers misleading--unable to confirm if markers correspond to this crossing. Need markers at levee. (W. Wylie) FIELD_STRUCT_DESC: 30-inch coated steel natural gas pipeline through the levee, approximately 60 feet below the crown. Gas line markers are visible on the waterside (WS) and the landside (LS). (30-inch horizontal directional bore (HDD) authorized under Permit No. 18568, 2010 - Gill Ranch Storage, LLC). FS Date: 7/19/2021

LS view: Toe from crown, marker way off in distance.

LS view: Closeup of marker with contact information.

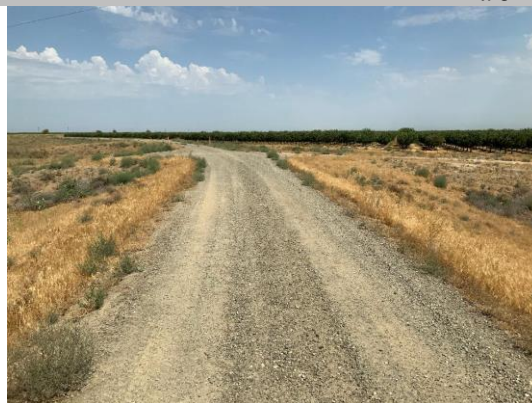
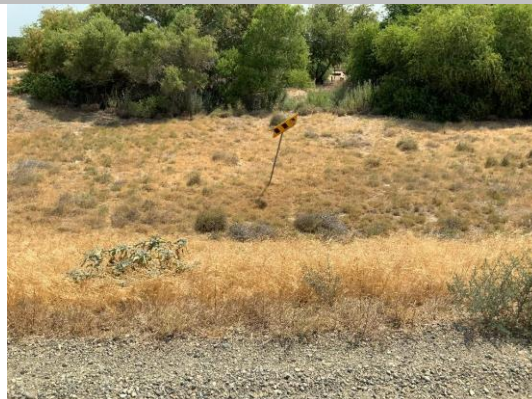
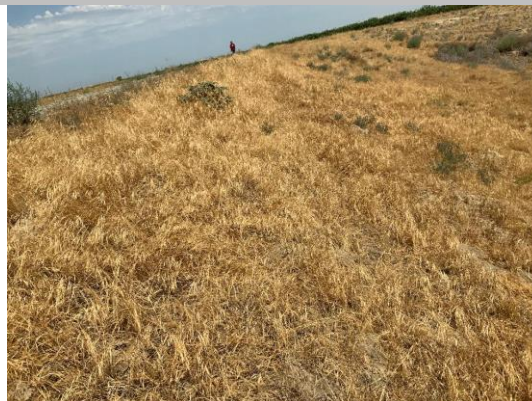
DS\_ID:19919  
 FS\_ID:68524  
 EP\_NO: 15399  
 Repair Type: Non-Urgent  
 EVAL Issue: Safety Issue  
 Crossing Status: Indicator Found  
 UCIP Comments: 07/19/2021 The record has been upgraded from No Action Needed to Non-Urgent. As a safety measure, need to coordinate with owner to determine status of line and to obtain maintenance and inspection records to confirm integrity of line through the levee. The UCIP inspection was completed with GEI staff, P. Espinoza. (H. Dunn – GEI)  
 FIELD\_STRUCT\_DESC: 6-inch natural gas pipeline of an unknown material through the levee, 3 feet below the crown. Gas line markers at both toes. (Plans to install a 6-inch welded steel natural gas pipeline under the channel and within both levees of the San Joaquin River and the Chowchilla Bypass authorized under Permit No. 15399, 1990 - California Gas Gathering, Inc.). [Additional Reference(s): DWR Levee Log, 2002 (HLM 14.41), listed as a 6-inch gas line].

LS view: Marker visible at toe from crown.

LS view: Slope from toe.

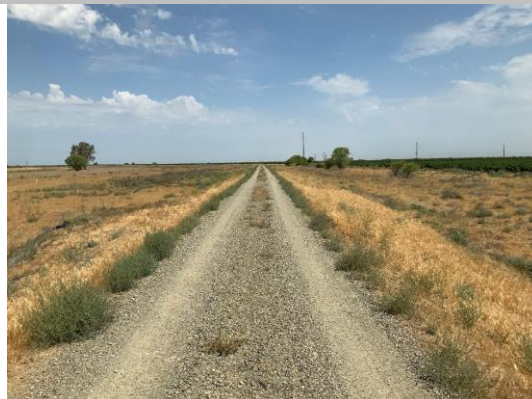
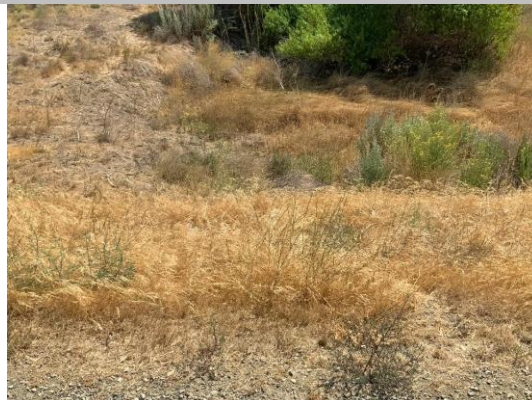
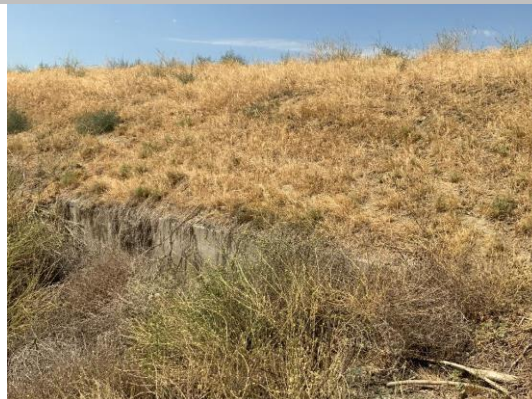
Comment Code						
Inspector Comment						
DS_ID:19920 FS_ID:68525 EP_NO: N/A Repair Type: Non-Urgent EVAL Issue: Limited Inspection/No UCIP Evaluation Crossing Status: Found UCIP Comments: 07/19/2021 The record remains Non-Urgent. Dense tumbleweeds over WS flapgate and LS inlet, recommend removal of both sides. Limited inspection on both WS and LS ends. No permit was found authorizing this encroachment. CVFPB will need to review crossing to determine owner. The UCIP inspection was completed with GEI staff, P. Espinoza. (H. Dunn – GEI) 04/01/2014 Heavy vegetation buildup at LS toe--recommend clearing. (W. Wylie - DWR UCIP) FIELD_STRUCT_DESC: 30-inch by 30-inch square reinforced concrete box gravity drainage culvert through the levee, 14 feet below the crown. Flap gate on the waterside (WS) end. Concrete headwall on the landside (LS) end. Concrete U-shaped headwall on the WS end. [Additional Reference(s): DWR Levee Log, 2002 (HLM 14.70), listed as a 30-inch square reinforced concrete box culvert (RCBC). USACE San Joaquin O&M Manual, Unit 601 Part 1 (SJR601.1), 1967, (HLM 14.69), listed as a 2.5-feet by 2.5-feet RCBC]. FS Date: 7/19/2021

LS view: Toe from crown.

LS view: Slope from toe.

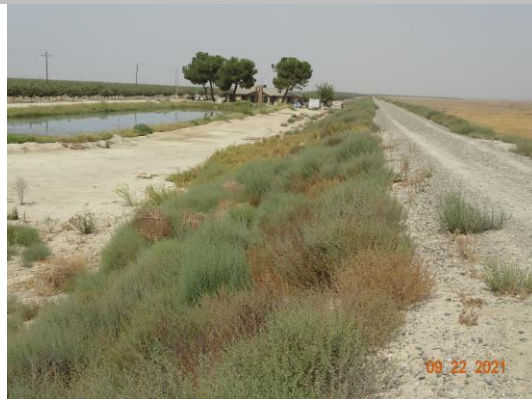
Photo 1 of 1 : FA\_2021\_NA0010\_137\_40\_20211006\_00055.jpg

LM Start	0.01	Rating **	M	Issue No.	40
LM End	1.66	Issue Type +	Ma	Location *	LS
Category	Earthen Levee			GPS Latitude/Longitude	
				Start	End
Item	Vegetation			36.974071 °	36.953178 °
				-120.363183 °	-120.351840 °
DWR ID	DWR_NA0010_18_f _ 2021_40				
Comment Code					
V1 : Control annual grass and weeds on the levee slopes and easements.					
Inspector Comment

View of vegetation on the landside slope. (Fall 2021)

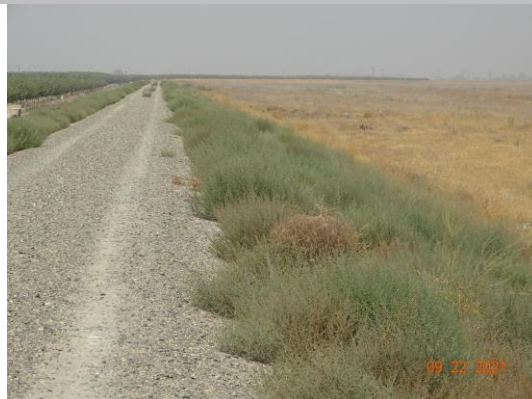
Photo 1 of 1 : FA\_2021\_NA0010\_137\_41\_20211006\_00056.jpg

LM Start	0.01	Rating **	M	Issue No.	41
LM End	1.65	Issue Type +	Ma	Location *	WS
Category	Earthen Levee			GPS Latitude/Longitude	
				Start	End
Item	Vegetation			36.974067 °	36.953329 °
				-120.363181 °	-120.351912 °
DWR ID	DWR_NA0010_18_f _ 2021_41				
Comment Code					
V1 : Control annual grass and weeds on the levee slopes and easements.					
Inspector Comment

Looking upstream along the waterside slope. (Fall 2021)

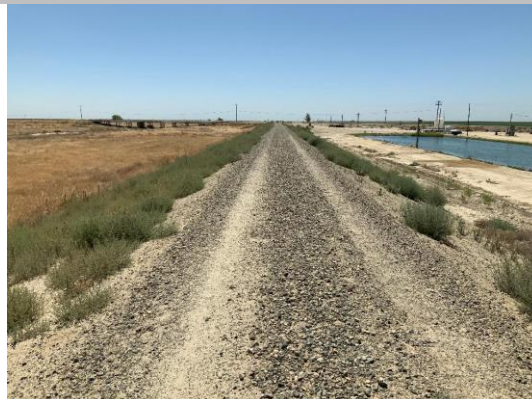
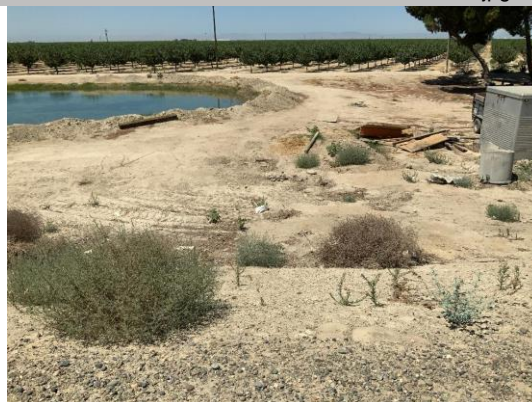
Comment Code						
Inspector Comment						
DS_ID:19923 FS_ID:68890 EP_NO: N/A Repair Type: Non-Urgent EVAL Issue: Pipe Not Found Crossing Status: Not Found UCIP Comments: 07/20/2021 The record is Non-Urgent. Pipe not found by visual inspection. DWR DMP geophysical study did not confirm presence of pipe through levee. Record will remain in UCIP's inspection records until future Levee Improvement Project can confirm no crossing was found through the levee. No permit was found authorizing this encroachment. CVFPB will need to review crossing to determine owner. The UCIP inspection was completed with GEI staff, P. Espinoza. (H. Dunn – GEI) FIELD_STRUCT_DESC: 8-inch corrugated metal gravity drainage pipe through the levee, 7 feet below the crown. Slide gate in a 36-inch corrugated metal pipe (CMP) riser on the waterside (WS) slope. Concrete headwall on the landside (LS) end. [Additional Reference(s): DWR Levee Log, 2002]. FS Date: 7/20/2021

LS view: Toe from crown, no pipe visible.

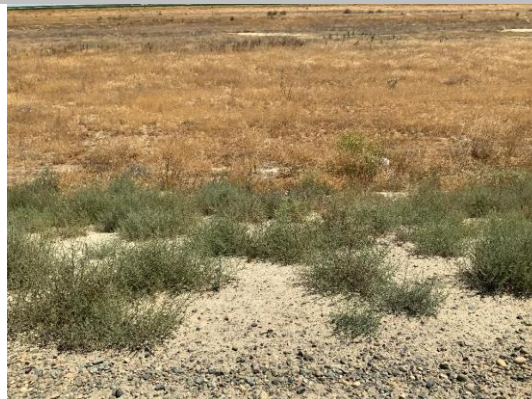
Photo 3 of 3 : UCIP\_FA\_2021\_68890\_102058.jpg

WS view: Toe from crown, no pipe visible.

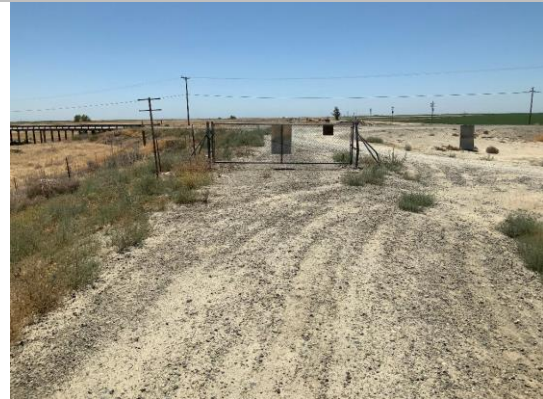
Photo 1 of 3 : UCIP\_FA\_2021\_68244\_102063.jpg

Comment Code					
Inspector Comment					
DS_ID:19924 FS_ID:68244 EP_NO: 11615 Repair Type: Non-Urgent EVAL Issue: Pipe Not Found Crossing Status: Not Found UCIP Comments: 07/20/2021 The record is Non-Urgent. Pipe not found by visual inspection. Confirm with owner on the status of this pipe. The UCIP inspection was completed with GEI staff, P. Espinoza. (H. Dunn – GEI) FIELD_STRUCT_DESC: 1-inch polyvinyl chloride (PVC) water line through the levee, 0.333 feet below the crown. Water line extends from a cattle water trough at the landside (LS) toe. (Plans to install livestock watering troughs and a 1-inch water pipeline through the levee, at three locations on the left bank of the Chowchilla Bypass authorized under Permit No. 11615, 1976 - John M. Lasgoity). [Additional Reference(s): DWR Levee Log, 2002]. FS Date: 7/20/2021

Levee crown.

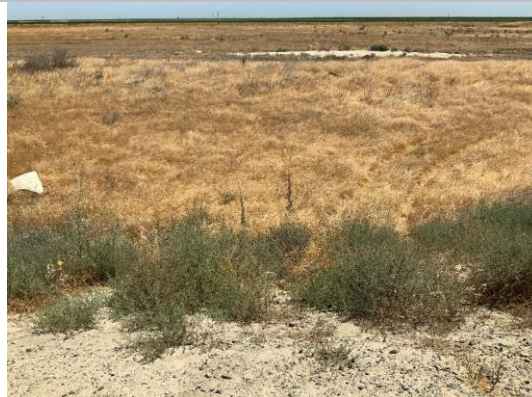
Photo 3 of 3 : UCIP\_FA\_2021\_68244\_102062.jpg

WS view: Toe from crown, no pipe visible.

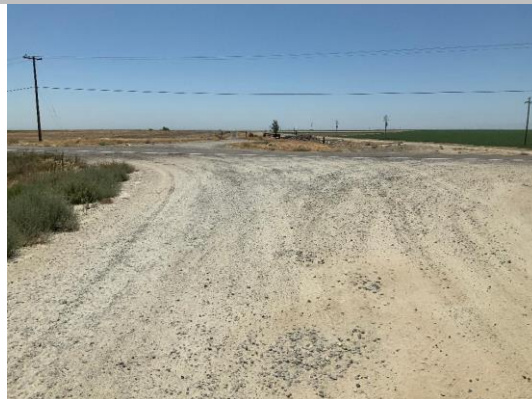
Photo 1 of 3 : UCIP\_FA\_2021\_68245\_102068.jpg

DS\_ID:19925  
FS\_ID:68245  
EP\_NO: 6603  
Repair Type: Non-Urgent  
EVAL Issue: Levee Damage or Threat for Levee Damage  
Crossing Status: Found  
UCIP Comments: 07/20/2021 The record remains Non-Urgent.  
Flowmeter and pump on pipe appears newer, likely not abandoned as stated in previous inspection. Some erosion around the flowmeter on WS slope. The UCIP inspection was completed with GEI staff, P. Espinoza. (H. Dunn – GEI) 04/10/2014 Need to contact owner. Appears abandoned--good candidate for video or pressure inspection. This crossings is the same age as the pipe that has failed immediately upstream. (DWR UCIP - O. Magana)  
FIELD\_STRUCT\_DESC: 15-inch steel irrigation discharge pipe through the levee, 4.3 feet below the crown. Electrical conduit of an unknown size or material through the levee, 4.3 feet below the crown. Siphon breaker on the landside (LS) shoulder. 36-inch concrete standpipe on the LS berm. Inlet facility on the waterside (WS) bank consisting of a pump, a 42-inch concrete standpipe, and a 20-inch concrete channel with an intake pipe and a cutoff wall. (Plans to install a pump and outlet pipe at two locations on the left bank levee of the Chowchilla Bypass authorized under Permit No. 6603, 1969 - Raymond N. Costales).

Levee crown.

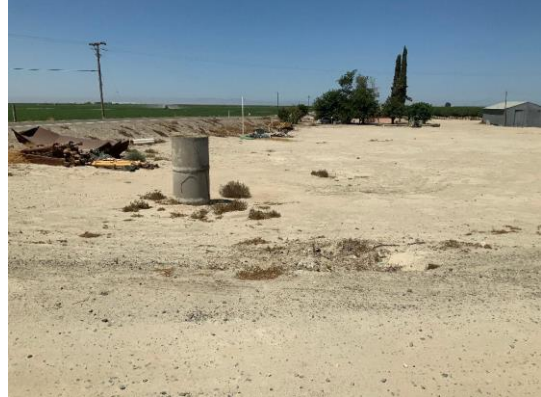
Photo 2 of 3 : UCIP\_FA\_2021\_68245\_102069.jpg

LS view: Toe from crown, riser visible.

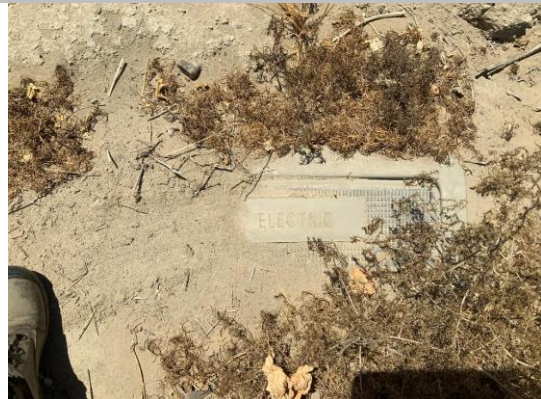
Photo 3 of 3 : UCIP\_FA\_2021\_68245\_102070.jpg

LS view: Electrical manhole off toe.

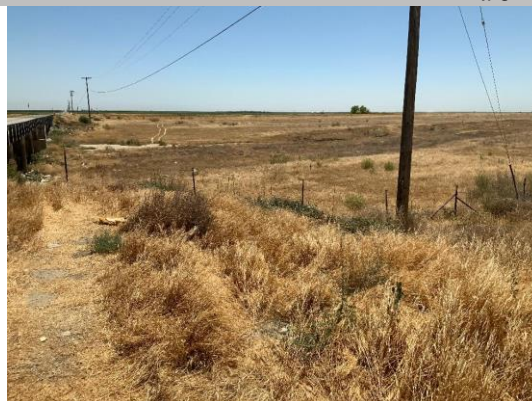
Photo 3 of 3 : UCIP\_FA\_2021\_68246\_102074.jpg

WS view: Toe from crown, no pipe visible.

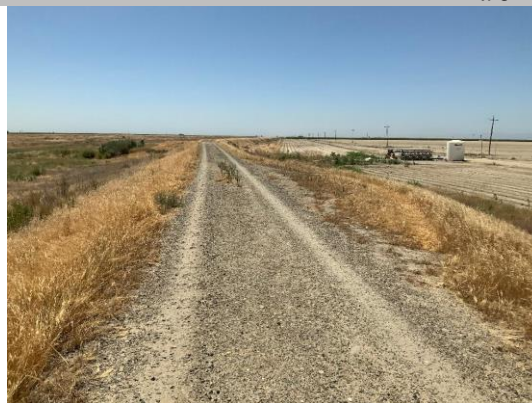
Photo 1 of 3 : UCIP\_FA\_2021\_68247\_102075.jpg

DS\_ID:19680  
 FS\_ID:68247  
 EP\_NO: 5837  
 Repair Type: Non-Urgent  
 EVAL Issue: Pipe Not Found  
 Crossing Status: Not Found  
 UCIP Comments: 07/20/2021 The record is Non-Urgent. Pipe not found by visual inspection. Confirm with owner on the status of this pipe. The UCIP inspection was completed with GEI staff, P. Espinoza. (H. Dunn – GEI)  
 FIELD\_STRUCT\_DESC: 2 of 2: 15-inch steel drainage discharge pipe through the levee, 2 feet below the crown. Channel inlet pipe and pump on the waterside (WS). Screw gate on WS with catwalk to access gate and pump. 20-inch irrigation pipe and standpipe on the landside (LS). (Plans for construction of two irrigation structures through the left bank levee of the Chowchilla Bypass authorized under Permit No. 5837, 1967 - Raymond N. Costales).  
 FS Date: 7/20/2021

Levee crown.

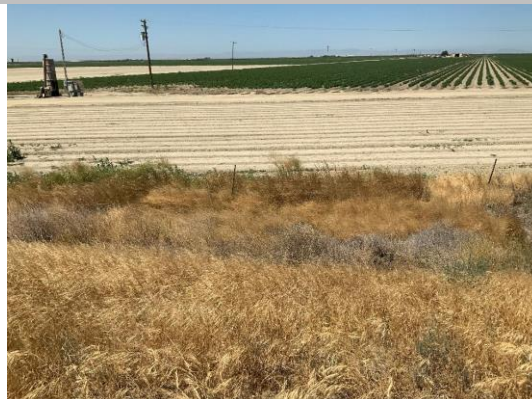
Photo 2 of 3 : UCIP\_FA\_2021\_68247\_102077.jpg

LS view: Toe from crown, no pipe visible.

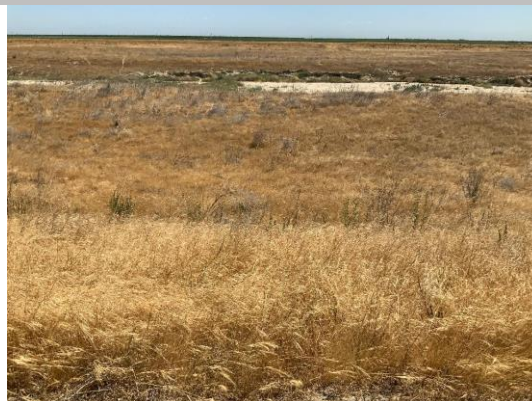
Photo 3 of 3 : UCIP\_FA\_2021\_68247\_102076.jpg

WS view: Toe from crown, no pipe visible.

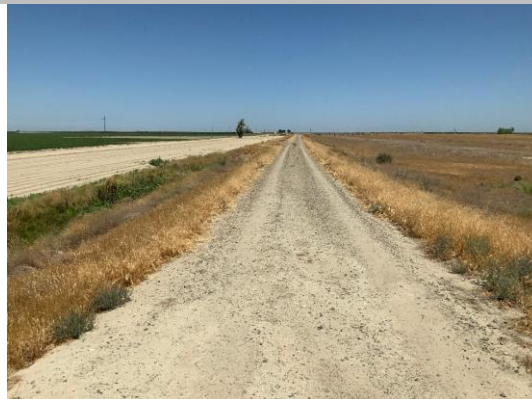
Photo 1 of 3 : UCIP\_FA\_2021\_68891\_102078.jpg

DS\_ID:19926  
 FS\_ID:68891  
 EP\_NO: 6603  
 Repair Type: Non-Urgent  
 EVAL Issue: Maintenance Compliance Issue  
 Crossing Status: Found  
 UCIP Comments: 07/20/2021 The record remains Non-Urgent. WS has some vegetation growth around the pump and pipe on the slope, recommend removal. No LS standpipe or siphon breaker visible and new filtration system set up landward off the LS toe. Unsure if pipe connected to filtration system and penetrating the ground on LS belongs to this crossing. Confirm with owner on the status of this pipe and the alignment. The UCIP inspection was completed with GEI staff, P. Espinoza. (H. Dunn – GEI) 7/20/2016 High burrow activity. Dense vegetation limits the inspector's visibility to identify signs of pipe failure (leaks) along the WS and LS slope. Recommend removing vegetation along pipe alignment to conduct proper inspection of structure and appurtenances. (DWR UCIP - omagana)4/10/2014 Subsidence present along pipe alignment on landward side. Modified crossing--worked done on landward side. Need to contact owner to determine permit authorizing work. Dense vegetation on landward side--tall grass. Pipe wall cut and new pipe sleeved on landward side. (DWR UCIP - omagana)

Levee crown.

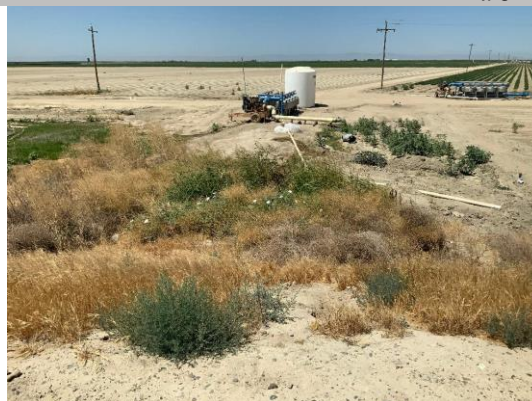
Photo 2 of 3 : UCIP\_FA\_2021\_68891\_102081.jpg

LS view: Toe from crown.

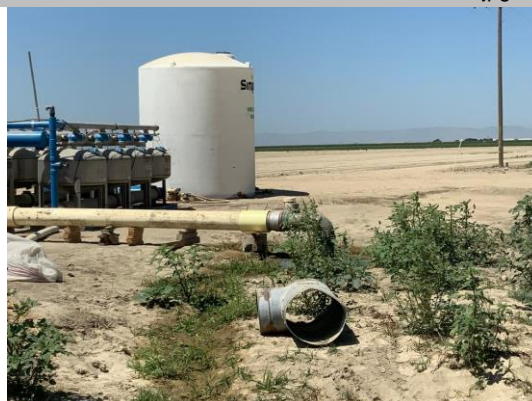
Photo 3 of 3 : UCIP\_FA\_2021\_68891\_102082.jpg

LS view: Closeup of new filtration system and pipe located landward of the levee toe.

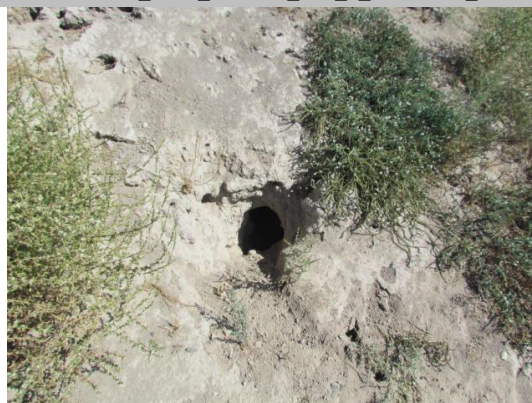
Photo 1 of 1 : FA\_2021\_NA0010\_137\_8\_20210830\_00002.jpg

LM Start	2.25	Rating **	U	Issue No.	8
LM End	2.25	Issue Type +	Ma	Location *	LS
Category	Earthen Levee			GPS Latitude/Longitude	
				Start	End
Item	Animal Control			36.945563 °	36.945563 °
				-120.347121 °	-120.347121 °
DWR ID	DWR_NA0010_18_f_2015_8				
Comment Code					
A3 : No rodents visible, but rodent burrows visible; need to backfill and compact or grout burrows.					
Inspector Comment					
There is one large rodent hole and other smaller rodent holes within this area.

Looking at large rodent hole on landward slope.

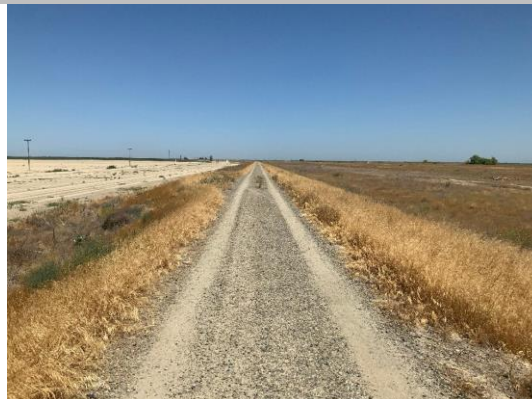
Photo 1 of 3 : UCIP\_FA\_2021\_68249\_102084.jpg

Comment Code						
Inspector Comment						
DS_ID:19729 FS_ID:68249 EP_NO: N/A Repair Type: Non-Urgent EVAL Issue: Pipe Not Found Crossing Status: Not Found UCIP Comments: 07/20/2021 The record is Non-Urgent. Pipe not found by visual inspection. DWR DMP geophysical study did not confirm presence of pipe through levee. Record will remain in UCIP's inspection records until future Levee Improvement Project can confirm no crossing was found through the levee. No permit was found authorizing this encroachment. CVFPB will need to review crossing to determine owner. The UCIP inspection was completed with GEI staff, P. Espinoza. (H. Dunn – GEI) FIELD_STRUCT_DESC: 24-inch corrugated metal gravity drainage pipe through the levee, 7.5 feet below the crown. Slide gate in a 36-inch corrugated metal pipe (CMP) riser on the waterside (WS) slope. Concrete U-shaped headwall on the landside (LS) end. [Additional Reference(s): DWR Levee Log, 2002]. FS Date: 7/20/2021

Levee crown.

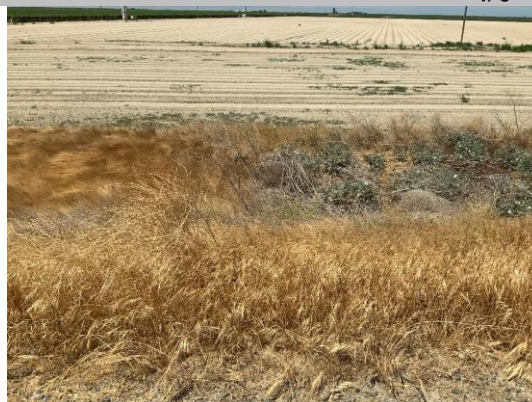
Photo 2 of 3 : UCIP\_FA\_2021\_68249\_102086.jpg

LS view: Toe from crown, no pipe visible.

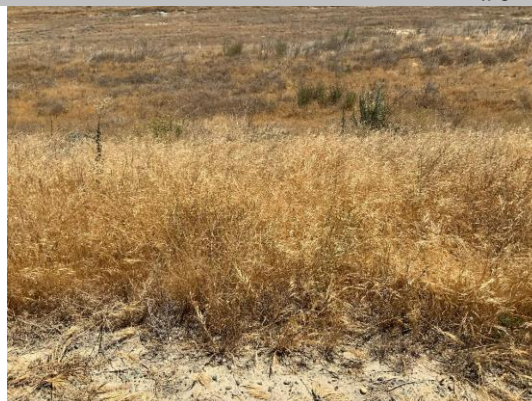
Photo 3 of 3 : UCIP\_FA\_2021\_68249\_102085.jpg

WS view: Toe from crown, no pipe visible.

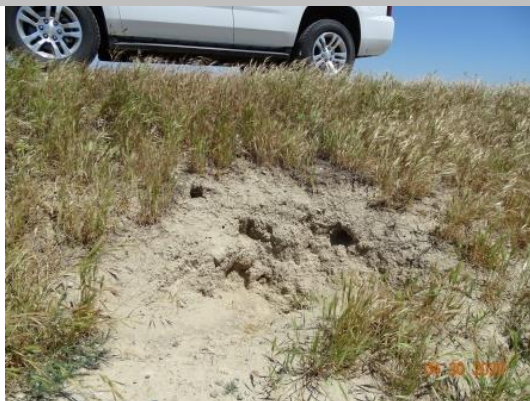
Photo 1 of 1 : FA\_2021\_NA0010\_137\_47\_20210830\_00011.jpg

LM Start	3.73	Rating **	U	Issue No.	47
LM End	3.73	Issue Type +	Ma	Location *	LS
Category	Earthen Levee			GPS Latitude/Longitude	
				Start	End
Item	Animal Control			36.924969 °	36.924969 °
				-120.339407 °	-120.339407 °
DWR ID	DWR_NA0010_18_s_2020_47				
Comment Code					
A3 : No rodents visible, but rodent burrows visible; need to backfill and compact or grout burrows.					
Inspector Comment

Large rodent burrow in the landside slope. (Spring 2020)

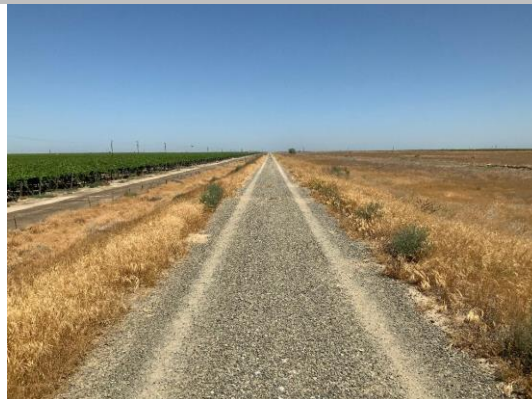
Photo 1 of 3 : UCIP\_FA\_2021\_68250\_102087.jpg

Comment Code					
Inspector Comment					
DS_ID:19928 FS_ID:68250 EP_NO: 11615 Repair Type: Non-Urgent EVAL Issue: Pipe Not Found Crossing Status: Not Found UCIP Comments: 07/20/2021 The record is Non-Urgent. Pipe not found by visual inspection. Confirm with owner on the status of this pipe. The UCIP inspection was completed with GEI staff, P. Espinoza. (H. Dunn – GEI) FIELD_STRUCT_DESC: 1-inch polyvinyl chloride (PVC) water line through the levee, 0.667 feet below the crown. Water line extends from a cattle water trough at the landside (LS) toe. (Plans to install livestock watering troughs and a 1-inch water pipeline through the levee, at three locations on the left bank of the Chowchilla Bypass authorized under Permit No. 11615, 1976 - John M. Lasgoity). [Additional Reference(s): DWR Levee Log, 2002]. FS Date: 7/20/2021

Levee crown.

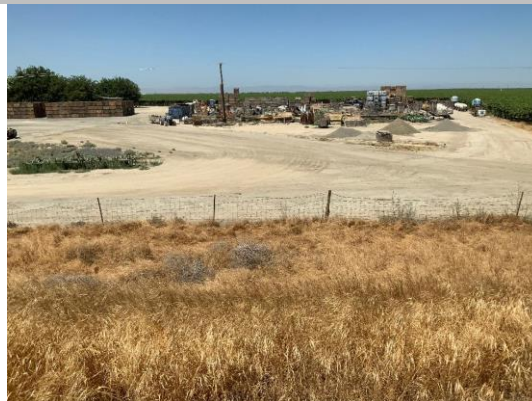
Photo 2 of 3 : UCIP\_FA\_2021\_68250\_102088.jpg

LS view: Toe from crown, no pipe visible.

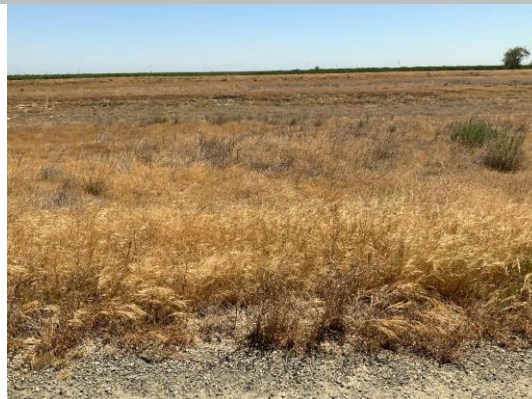
Photo 3 of 3 : UCIP\_FA\_2021\_68250\_102089.jpg

WS view: Toe from crown, no pipe visible.

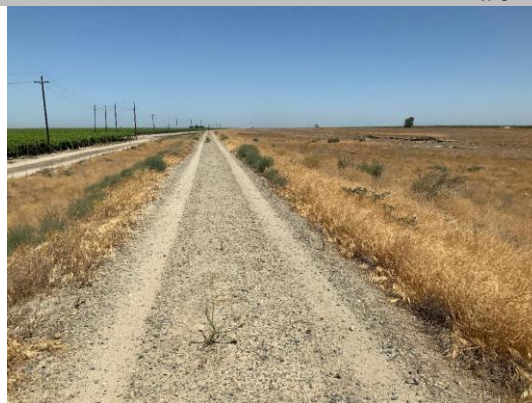
Photo 1 of 3 : UCIP\_FA\_2021\_68251\_102090.jpg

Comment Code						
Inspector Comment						
DS_ID:19929 FS_ID:68251 EP_NO: N/A Repair Type: Non-Urgent EVAL Issue: Pipe Not Found Crossing Status: Not Found UCIP Comments: 07/20/2021 The record is Non-Urgent. Pipe not found by visual inspection. DWR DMP geophysical study did not confirm presence of pipe through levee. Record will remain in UCIP's inspection records until future Levee Improvement Project can confirm no crossing was found through the levee. No permit was found authorizing this encroachment. CVFPB will need to review crossing to determine owner. The UCIP inspection was completed with GEI staff, P. Espinoza. (H. Dunn – GEI) FIELD_STRUCT_DESC: 48-inch corrugated metal gravity drainage pipe through the levee, 10 feet below the crown. Slide gate in a 60-inch corrugated metal pipe (CMP) riser on the waterside (WS) slope. Concrete headwall on the landside (LS) end. WS end capped with a 0.25-inch steel plate. [Additional Reference(s): DWR Levee Log, 2002]. FS Date: 7/20/2021

Levee crown.

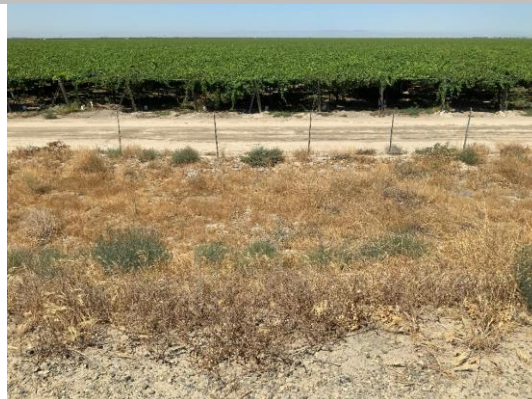
Photo 2 of 3 : UCIP\_FA\_2021\_68251\_102091.jpg

LS view: Toe from crown, no pipe visible.

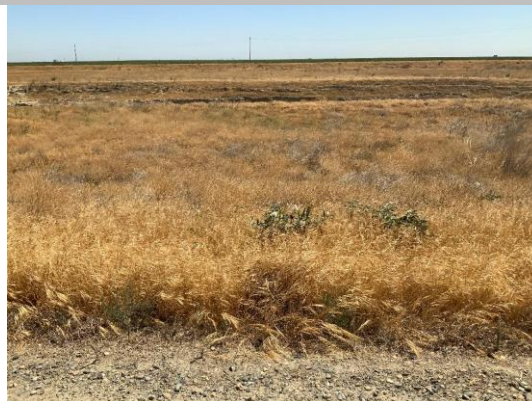
Photo 3 of 3 : UCIP\_FA\_2021\_68251\_102092.jpg

WS view: Toe from crown, no pipe visible.

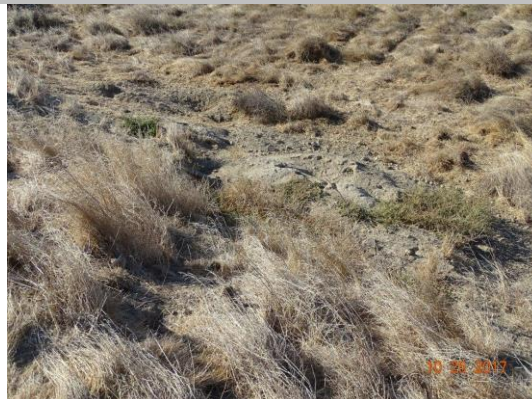
Photo 1 of 1 : FA\_2021\_NA0010\_137\_15\_20210830\_00005.jpg

LM Start	5.74	Rating **	U	Issue No.	15
LM End	5.99	Issue Type +	Ma	Location *	LS
Category	Earthen Levee			GPS Latitude/Longitude	
				Start	End
Item	Animal Control			36.897237 °	36.893924 °
				-120.328633 °	-120.327020 °
DWR ID	DWR_NA0010_18_f _ 2017_15				
Comment Code					
A3 : No rodents visible, but rodent burrows visible; need to backfill and compact or grout burrows.					
Inspector Comment					
There are multiple large rodent holes at the landside toe.

Looking west at the landside slope. (Fall 2017)

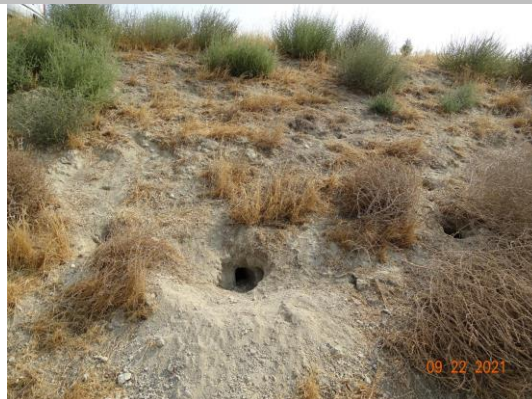
Photo 1 of 1 : FA\_2021\_NA0010\_137\_35\_20211006\_00057.jpg

LM Start	6.62	Rating **	M	Issue No.	35
LM End	6.62	Issue Type +	Ma	Location *	LS
Category	Earthen Levee			GPS Latitude/Longitude	
				Start	End
Item	Animal Control			36.885376 °	36.885376 °
				-120.322820 °	-120.322820 °
DWR ID	DWR_NA0010_18_f _ 2021_35				
Comment Code					
A3 : No rodents visible, but rodent burrows visible; need to backfill and compact or grout burrows.					
Inspector Comment

Looking at rodent holes on the landside slope. (Fall 2021)

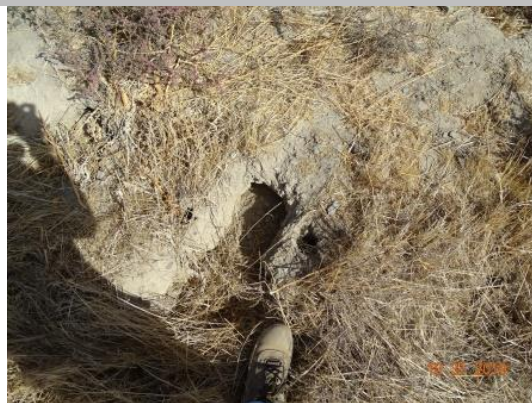
Photo 1 of 1 : FA\_2021\_NA0010\_137\_23\_20210830\_00009.jpg

LM Start	6.84	Rating **	U	Issue No.	23
LM End	6.84	Issue Type +	Ma	Location *	LS
Category	Earthen Levee			GPS Latitude/Longitude	
				Start	End
Item	Animal Control			36.882384 °	36.882384 °
				-120.321417 °	-120.321417 °
DWR ID	DWR_NA0010_18_f_2019_23				
Comment Code					
A1 : Exterminate rodents and backfill and compact or grout burrows.					
Inspector Comment

Representative view of rodent burrows observed at this location. (Fall 2019)

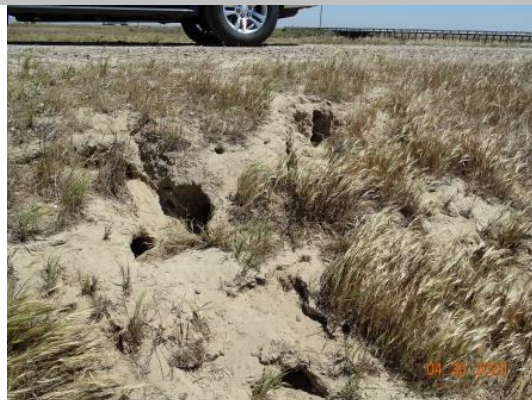
Photo 1 of 1 : FA\_2021\_NA0010\_137\_14\_20210830\_00004.jpg

LM Start	7.39	Rating **	U	Issue No.	14
LM End	7.53	Issue Type +	Ma	Location *	LS
Category	Earthen Levee			GPS Latitude/Longitude	
				Start	End
Item	Animal Control			36.874479 °	36.872503 °
				-120.319831 °	-120.319438 °
DWR ID	DWR_NA0010_18_f_2017_14				
Comment Code					
A3 : No rodents visible, but rodent burrows visible; need to backfill and compact or grout burrows.					
Inspector Comment					
There are several rodent holes noted along the landside slope in this area.

View of rodent burrows in the landside slope. (Spring 2020)

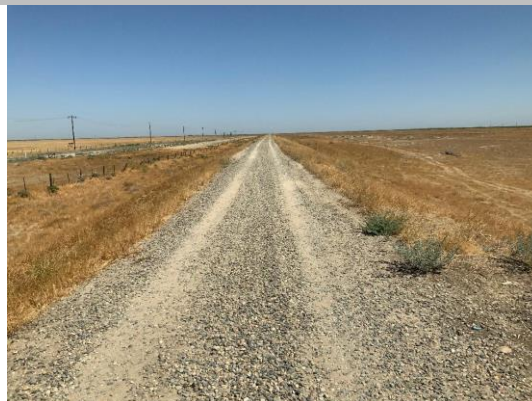
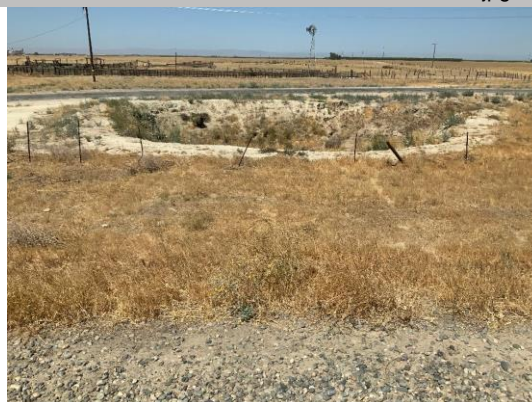
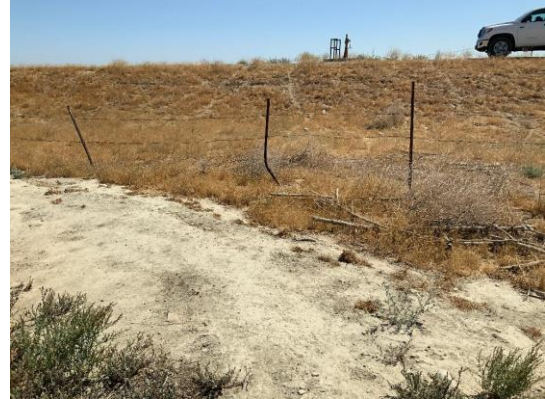
DS\_ID:19930  
FS\_ID:68892  
EP\_NO: 13548  
Repair Type: Non-Urgent  
EVAL Issue: Maintenance Compliance Issue  
Crossing Status: Found  
UCIP Comments: 07/20/2021 The record remains Non-Urgent. No longer debris or sediment inside LS pipe outlet. WS pipe does not appear to be distorted, but has minor vegetation over inlet, recommend removal. The UCIP inspection was completed with GEI staff, P. Espinoza. (H. Dunn – GEI) 04/10/2014 CMP crossing is distorted on waterward side. Debris scattered on landward side. Sediment deposit inside crossing visible from landward side. Recommend removing debris from landward side. (DWR UCIP - O. Magana)  
FIELD\_STRUCT\_DESC: 42-inch reinforced concrete gravity irrigation pipe through the levee, 19 feet below the crown. Gate structure on the waterside (WS) shoulder. Pipe section on the WS is corrugated metal. Pipe section on the landside (LS) is reinforced concrete. (Plans to install a 42-inch gravity-flow concrete pipeline through the left bank levee of the Eastside Bypass to divert bypass waters for irrigation purposes authorized under Permit No. 13548, 1983 - New Stone Water District). [Additional Reference(s): DWR Levee Log, 2002].

Levee crown.

LS view: Toe from crown.

LS view: Slope from toe.
