## Flood Control Project Maintenance Levee Inspections

### Fall 2021 Levee Maintenance Deficiency Summary Report

#### San Joaquin River Basin

NA0010 Lower San Joaquin Levee District	Overall LMA Rating	Total LMA Miles							
	U	191.27							
Rated Item	Maintenance Deficiency				Enforcement		Design & System Obsolescence		
	M Miles	U Miles	M + 4U Miles	Threshold %	M Miles	U Miles	M Miles	U Miles	
<i>Earthen Levee</i>									
Vegetation	47.00	9.57	85.28	44.59%					
Trim / Thin Trees	0.10		0.10	0.05%					
Encroachments	0.23	0.02	0.31	0.16%	9.29	0.59			
Animal Control	7.67	2.19	16.43	8.59%					
Slope Stability	0.05	0.01	0.09	0.05%					
Erosion / Bank Caving	0.13	0.81	3.37	1.76%					
Crown Surface / Depressions / Rutting	0.01		0.01	0.01%					
Repair Gates	0.02	0.02	0.10	0.05%					
<i>Rivers, Channels &amp; Designated Floodways</i>									
Encroachments					0.01	0.01			
<i>Supplemental</i>									
DWR Erosion Survey	0.12	0.17	0.80	0.42%					
DWR UCIP Field Study					1.29	0.05			
DWR UCIP LMA Responsibility									
<i>LMA Totals:</i>	55.33	12.79	106.49	55.67%	10.59	0.65	0.00	0.00

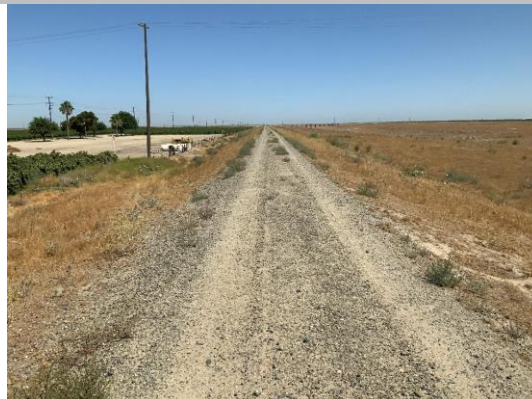
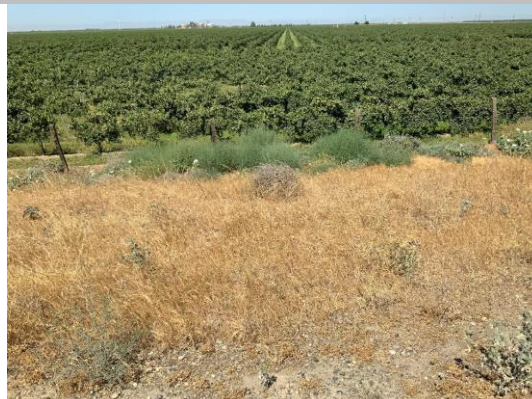
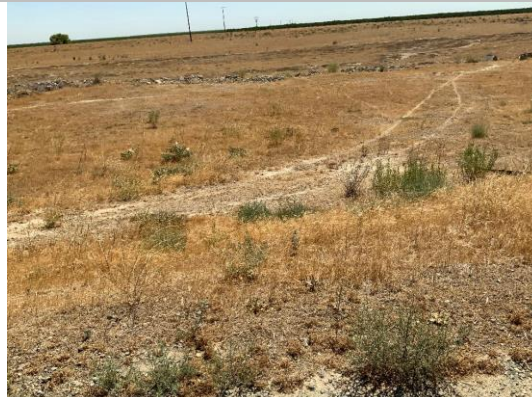
DS\_ID:19931  
FS\_ID:68253  
EP\_NO: 11615  
Repair Type: Non-Urgent  
EVAL Issue: Pipe Not Found  
Crossing Status: Not Found  
UCIP Comments: 07/20/2021 The record is Non-Urgent. Pipe not found by visual inspection. Confirm with owner on the status of this pipe. The UCIP inspection was completed with GEI staff, P. Espinoza. (H. Dunn – GEI)  
FIELD\_STRUCT\_DESC: 1-inch polyvinyl chloride (PVC) water line through the levee, 2 feet below the crown. Water line extends from a cattle water trough at the landside (LS) toe. (Plans to install livestock watering troughs and a 1-inch water pipeline through the levee, at three locations on the left bank of the Chowchilla Bypass authorized under Permit No. 11615, 1976 - John M. Lasgoity). [Additional Reference(s): DWR Levee Log, 2002].  
FS Date: 7/20/2021

LS view: Toe from crown, no pipe visible.

WS view: Toe from crown, no pipe visible.

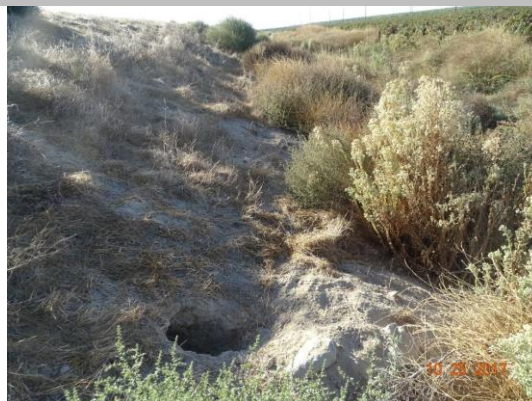
Photo 1 of 1 : FA\_2021\_NA0010\_137\_13\_20210830\_00003.jpg

LM Start	8.67	Rating **	U	Issue No.	13
LM End	8.67	Issue Type +	Ma	Location *	LS
Category	Earthen Levee			GPS Latitude/Longitude	
				Start	End
Item	Animal Control			36.856115 °	36.856115 °
				-120.316595 °	-120.316595 °
DWR ID	DWR_NA0010_18_f_2017_13				
Comment Code					
A3 : No rodents visible, but rodent burrows visible; need to backfill and compact or grout burrows.					
Inspector Comment

Looking south at the landside slope.

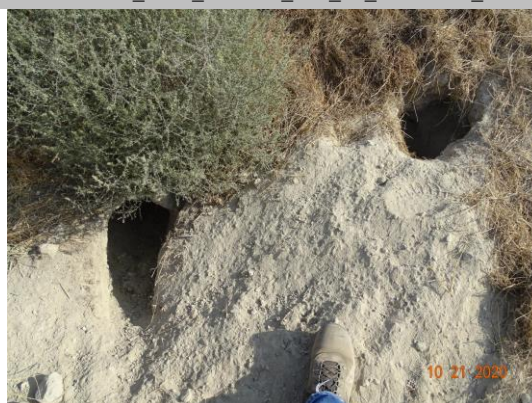
Photo 1 of 1 : FA\_2021\_NA0010\_137\_18\_20210830\_00007.jpg

LM Start	8.89	Rating **	U	Issue No.	18
LM End	8.89	Issue Type +	Ma	Location *	LS
Category	Earthen Levee			GPS Latitude/Longitude	
				Start	End
Item	Animal Control			36.852936 °	36.852936 °
				-120.316451 °	-120.316451 °
DWR ID	DWR_NA0010_18_f_2020_18				
Comment Code					
A3 : No rodents visible, but rodent burrows visible; need to backfill and compact or grout burrows.					
Inspector Comment

Large rodent holes in the landside slope. (Fall 2020)

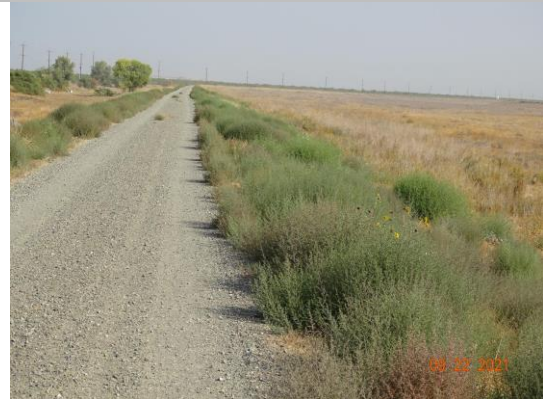
Photo 1 of 1 : FA\_2021\_NA0010\_137\_34\_20211006\_00058.jpg

LM Start	13.02	Rating **	M	Issue No.	34
LM End	13.20	Issue Type +	Ma	Location *	WS
Category	Earthen Levee			GPS Latitude/Longitude	
				Start	End
Item	Vegetation			36.799422 °	36.796908 °
				-120.308851 °	-120.308473 °
DWR ID	DWR_NA0010_18_f_2021_34				
Comment Code					
V1 : Control annual grass and weeds on the levee slopes and easements.					
Inspector Comment

View of the waterside slope looking downstream. (Fall 2021)

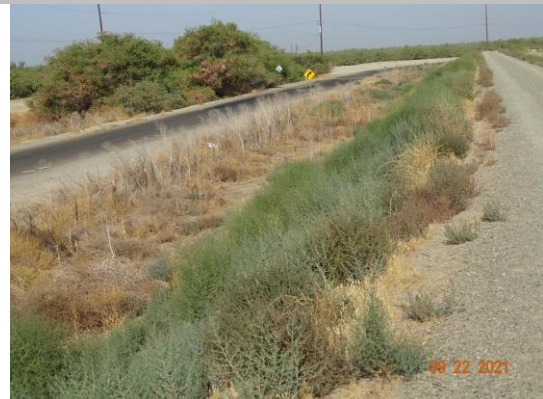
Photo 1 of 1 : FA\_2021\_NA0010\_137\_33\_20211006\_00059.jpg

LM Start	13.14	Rating **	M	Issue No.	33
LM End	13.50	Issue Type +	Ma	Location *	LS
Category	Earthen Levee			GPS Latitude/Longitude	
				Start	End
Item	Vegetation			36.797801 °	36.793367 °
				-120.308612 °	-120.306006 °
DWR ID	DWR_NA0010_18_f _ 2021_33				
Comment Code					
V1 : Control annual grass and weeds on the levee slopes and easements.					
Inspector Comment

Looking downstream along the landside slope. (Fall 2021)

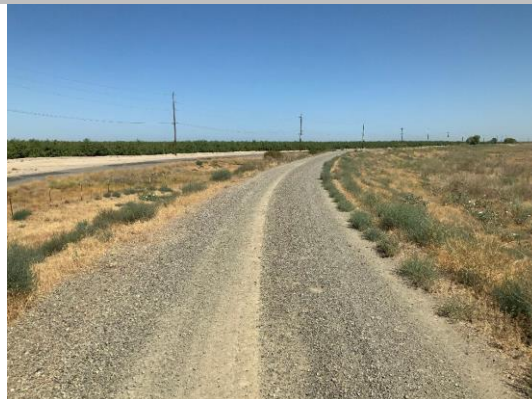
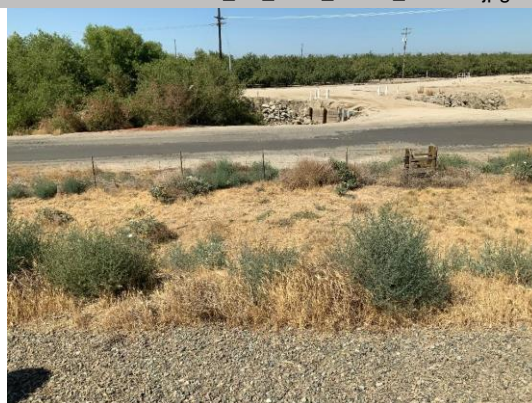
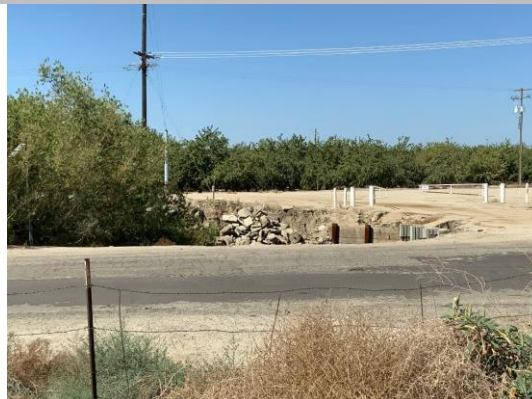
DS\_ID:19569  
FS\_ID:68893  
EP\_NO: 13049  
Repair Type: Non-Urgent  
EVAL Issue: Limited Inspection/No UCIP Evaluation  
Crossing Status: Found  
UCIP Comments: 07/20/2021 The record has been upgraded from No Action Needed to Non-Urgent. LS pipe inlet is across the road and behind barbed wire, could not access, limited inspection. WS pipe outlet has sediment buildup inside, recommend removal. The UCIP inspection was completed with GEI staff, P. Espinoza. (H. Dunn – GEI)  
FIELD\_STRUCT\_DESC: 36-inch reinforced concrete gravity drainage pipe through the levee, 14.8 feet below the crown. Gate structure on the waterside (WS) slope. Standpipe on the WS end. Riprap on the landside (LS) slope. (Plans to install a 36-inch reinforced concrete pipe through the levee authorized under Permit No. 13049, 1981 - Newhall Land and Farming Company). [Additional Reference(s): DWR Levee Log, 2002].  
FS Date: 7/20/2021

LS view: Toe from crown.

LS view: Pipe inlet across road and behind barbed wire.

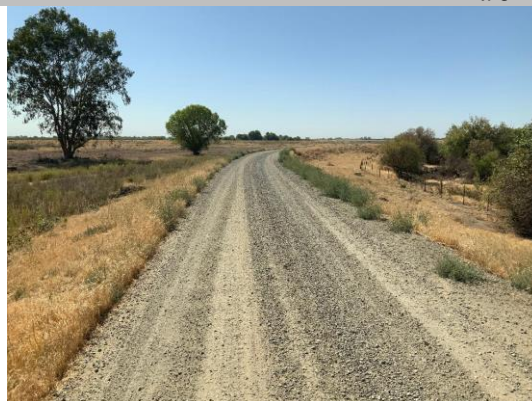
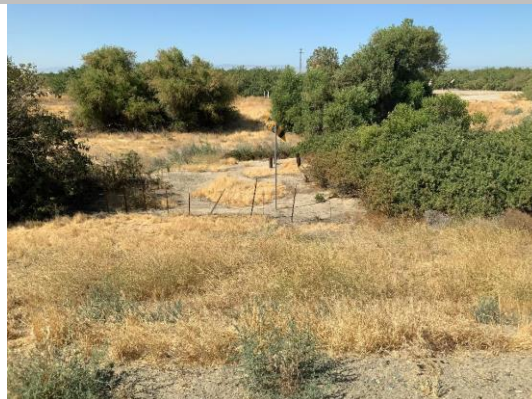
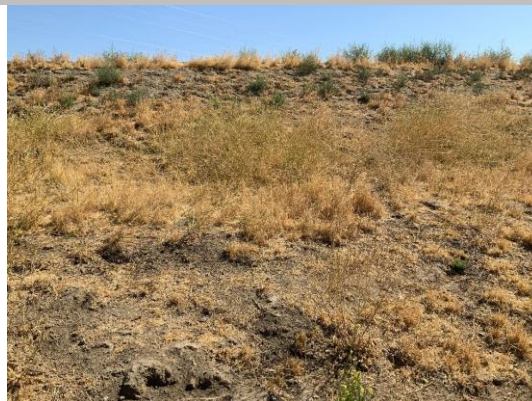
DS\_ID:19932  
 FS\_ID:68255  
 EP\_NO: N/A  
 Repair Type: Non-Urgent  
 EVAL Issue: Unauthorized Encroachment, installed decades prior  
 Crossing Status: Indicator Found  
 UCIP Comments: 07/20/2021 The record remains Non-Urgent. As previous inspection stated, contact owner to confirm alignment. Markers are visible on LS and WS but the way they are facing makes it appear that the line is going parallel to the levee and not through it. No permit was found authorizing this encroachment. CVFPB will need to review crossing to determine owner. The UCIP inspection was completed with GEI staff, P. Espinoza. (H. Dunn – GEI) 04/08/2014 Multiple markers visible along waterward and landward sides unable to confirm how many crossings go through levee. Need to contact owner to obtain additional details on crossings. (DWR UCIP - O. Magana)  
 FIELD\_STRUCT\_DESC: 6-inch natural gas pipeline of an unknown material through the levee. Pipeline extends underneath the channel.

LS view: Marker visible off the toe from crown.

LS view: Slope from toe.

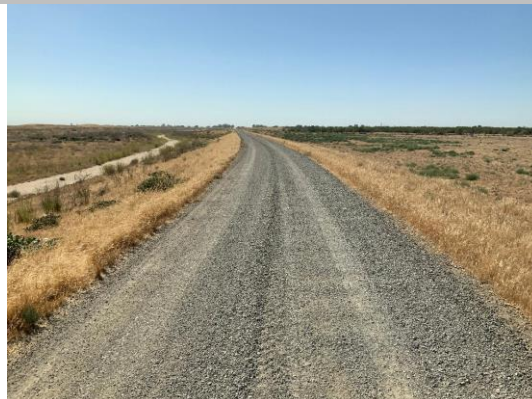
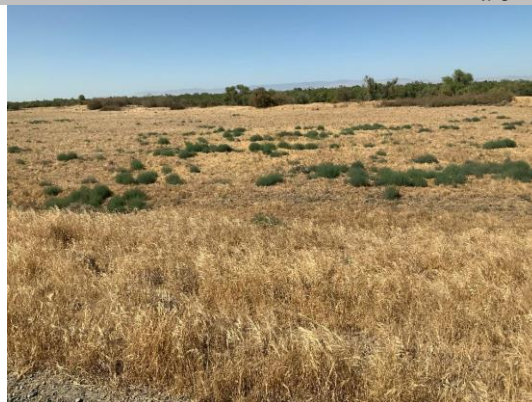
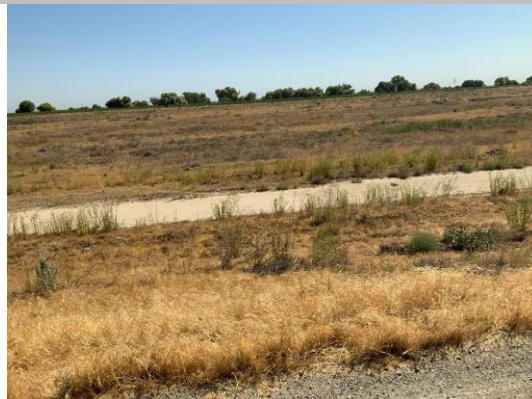
Comment Code					
Inspector Comment					
DS_ID:19682 FS_ID:68256 EP_NO: 6187 Repair Type: Non-Urgent EVAL Issue: Pipe Not Found Crossing Status: Not Found UCIP Comments: 07/20/2021 The record is Non-Urgent. Pipe not found by visual inspection. Confirm with owner on the status of this pipe. The UCIP inspection was completed with GEI staff, P. Espinoza. (H. Dunn – GEI) FIELD_STRUCT_DESC: 18-inch irrigation discharge pipe of an unknown material on the levee crown, placed in a mound fill, 2 feet deep. Pump on the riverbank. (Plans for installation of a pump on the riverbank and installation of a discharge pipe over the levee authorized under Permit No. 6187, 1967 - Newhall Land and Farming Company). FS Date: 7/20/2021

LS view: Toe from crown, no pipe visible.

WS view: Toe from crown, no pipe visible.

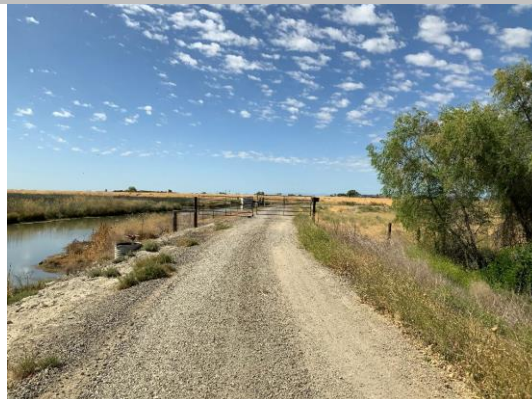
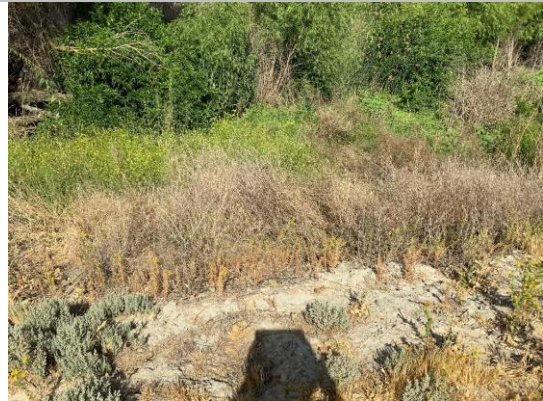
Comment Code						
Inspector Comment						
DS_ID:19933 FS_ID:69879 EP_NO: N/A Repair Type: Non-Urgent EVAL Issue: Safety Issue Crossing Status: Found UCIP Comments: 06/09/2021 The record remains Non-Urgent. Limited inspection of LS due to dense vegetation; recommend removal. Limited inspection on WS due to elevated water level. No pipe inlet or outlet was visible on LS or WS. Riser on WS missing lid, causing a safety hazard. No permit was found authorizing this encroachment. CVFPB will need to review crossing to determine owner. The UCIP inspection was completed with GEI staff, H.Dunn. (P.Espinoza – GEI)  07/19/2016 Gate inside riser appears operable--riser lid damage. Crossing is not visible on LS due to dense vegetation. Recommend clearing dense vegetation along WS and LS slope and repairing riser cover. (O. Magana - DWR UCIP)04/15/2014 No actuator wheel on slide gate at WS shoulder. (W. Wylie - DWR UCIP) FIELD_STRUCT_DESC: 24-inch corrugated metal gravity drainage pipe through the levee, 14.8 feet below the crown. Slide gate in a 36-inch corrugated metal pipe (CMP) riser on the waterside (WS) slope. Concrete U-shaped headwall on each end. [Additional Reference(s): DWR Levee Log, 2002 (HLM 0.10), listed as a 24-inch corrugated metal pipe (CMP). USACE San Joaquin O&M Manual, Unit 601 Part 1 (SJR601.1), 1967, Revised 25 May 2011, (HLM 0.10), listed as a 24-inch CMP]. FS Date: 6/9/2021 12:38:00 PM

View from levee crown. CMP riser visible on WS.

LS view: Toe from crown, dense vegetation.

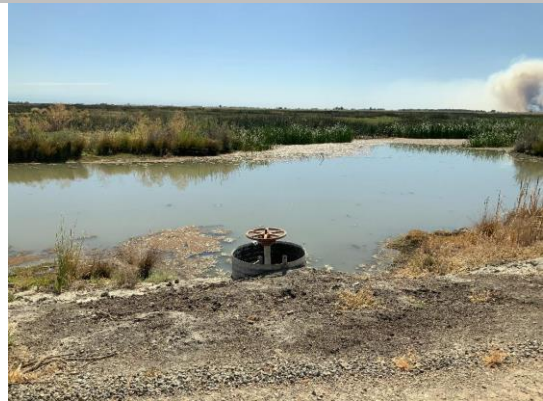
Photo 3 of 3 : UCIP\_FA\_2021\_69879\_103854.jpg

WS view: Slope from crown, CMP riser visible at toe.

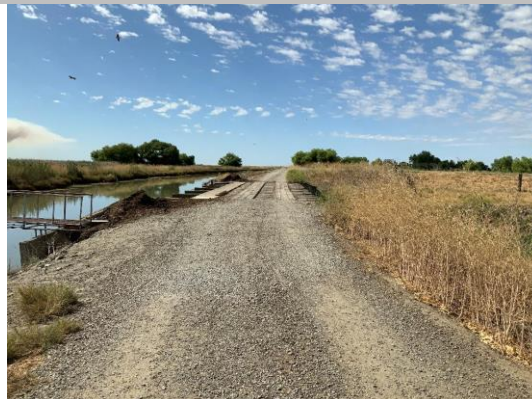
Photo 1 of 3 : UCIP\_FA\_2021\_69772\_103857.jpg

Comment Code						
Inspector Comment						
DS_ID:19934 FS_ID:69772 EP_NO: N/A Repair Type: Non-Urgent EVAL Issue: Unauthorized Encroachment, installed decades prior Crossing Status: Found UCIP Comments: 06/09/2021 The record has been upgraded from No Action Needed to Non-Urgent. Structure is functioning and in good standing. No permit was found authorizing this encroachment. CVFPB will need to review crossing to determine owner. The UCIP inspection was completed with GEI staff, H.Dunn. (P.Espinoza – GEI)  10/27/2017 This structure is inspected annually under the Structure and Channel Summer Inspection (part of the Levee Inspection Program) conducted by the DWR Flood Project Integrity and Inspection Branch (FPIIB). (O. Magana - DWR UCIP) FIELD_STRUCT_DESC: [Owens Creek Irrigation Structure] 1 of 7: 96-inch by 168-inch reinforced concrete gravity irrigation opening. Metal slots on the waterside (WS) for wooden flashboards. Timber bridge across irrigation structure. [Additional Reference(s): DWR Levee Log, 2002 (HLM 1.00), listed as a seven 8-foot by 14-foot reinforced concrete structure, known as Owens Creek Structure]. FS Date: 6/9/2021 1:03:00 PM

View from levee crown.

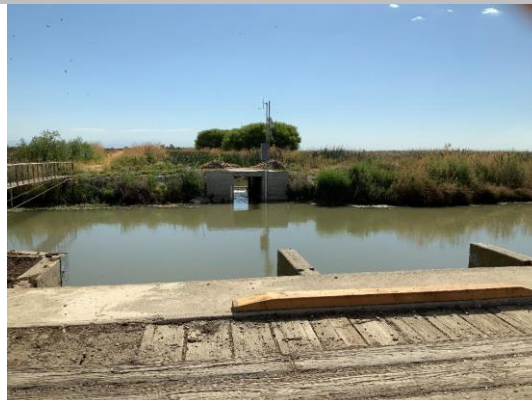
Photo 2 of 3 : UCIP\_FA\_2021\_69772\_103858.jpg

LS view: From timber bridge.

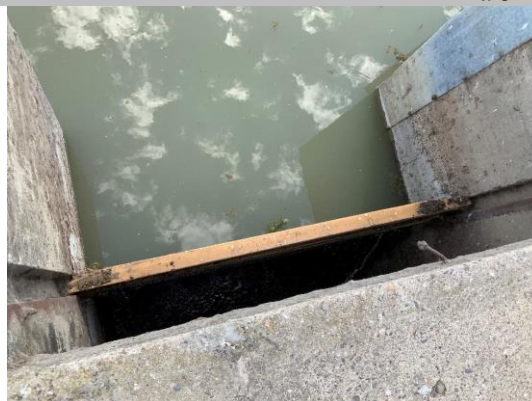
Photo 3 of 3 : UCIP\_FA\_2021\_69772\_103859.jpg

LS view from timber bridge: wooden flashboards in metal slots.

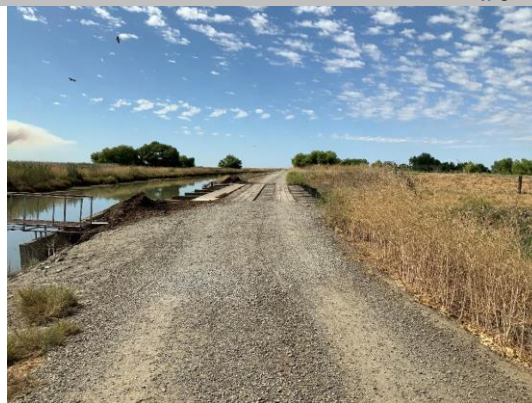
Photo 1 of 3 : UCIP\_FA\_2021\_69751\_103863.jpg

UCIP Comments: 06/09/2021 The record has been upgraded from No Action Needed to Non-Urgent. Structure is functioning and in good standing. No permit was found authorizing this encroachment. CVFPB will need to review crossing to determine owner. The UCIP inspection was completed with GEI staff, H.Dunn. (P.Espinoza – GEI)

View from levee crown.

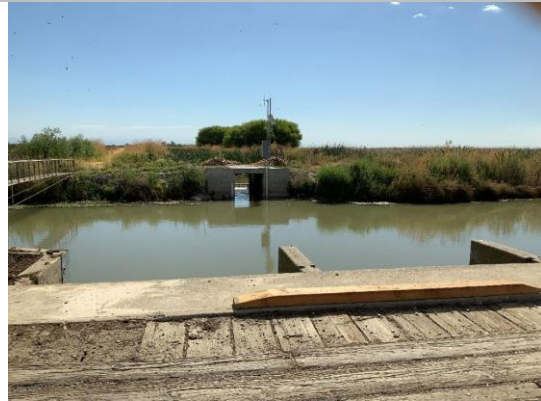
Photo 2 of 3 : UCIP\_FA\_2021\_69751\_103864.jpg

LS view from timber bridge.

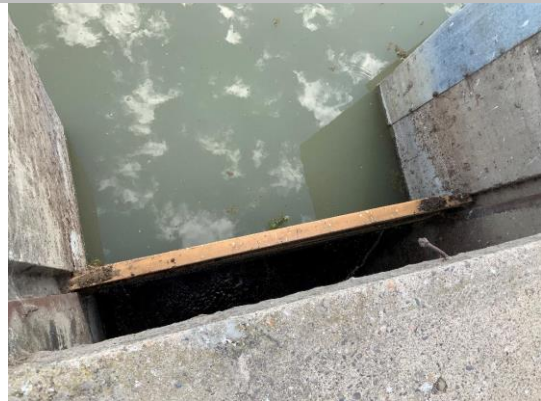
Photo 3 of 3 : UCIP\_FA\_2021\_69751\_103865.jpg

LS view from timber bridge.

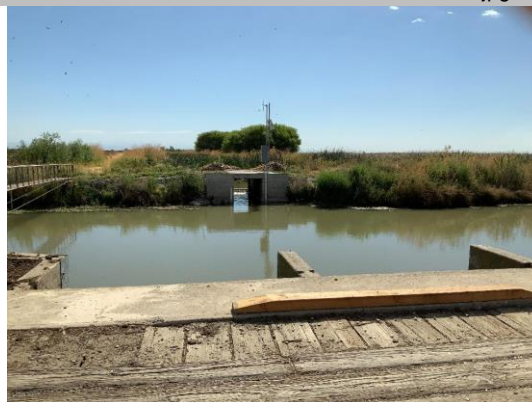
Photo 2 of 3 : UCIP\_FA\_2021\_69752\_103870.jpg

Comment Code						
Inspector Comment						
DS_ID:19720 FS_ID:69752 EP_NO: N/A Repair Type: Non-Urgent EVAL Issue: Unauthorized Encroachment, installed decades prior Crossing Status: Found UCIP Comments: 06/09/2021 The record has been upgraded from No Action Needed to Non-Urgent. Structure is functioning and in good standing. No permit was found authorizing this encroachment. CVFPB will need to review crossing to determine owner. The UCIP inspection was completed with GEI staff, H.Dunn. (P.Espinoza – GEI)  10/27/2017 This structure is inspected annually under the Structure and Channel Summer Inspection (part of the Levee Inspection Program) conducted by the DWR Flood Project Integrity and Inspection Branch (FPIIB). (O. Magana - DWR UCIP) FIELD_STRUCT_DESC: [Owens Creek Irrigation Structure] 3 of 7: 96-inch by 168-inch reinforced concrete gravity irrigation opening. Metal slots on the waterside (WS) for wooden flashboards. Timber bridge across irrigation structure. [Additional Reference(s): DWR Levee Log, 2002 (HLM 1.00), listed as a seven 8-foot by 14-foot reinforced concrete structure, known as Owens Creek Structure] FS Date: 6/9/2021 1:38:00 PM

LS view from timber bridge.

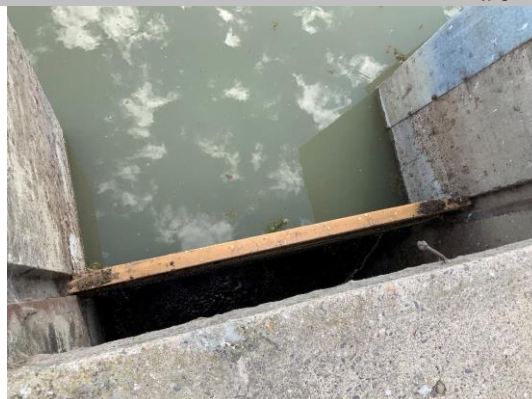
Photo 3 of 3 : UCIP\_FA\_2021\_69752\_103871.jpg

LS view from timber bridge: wooden flashboards in metal slots.

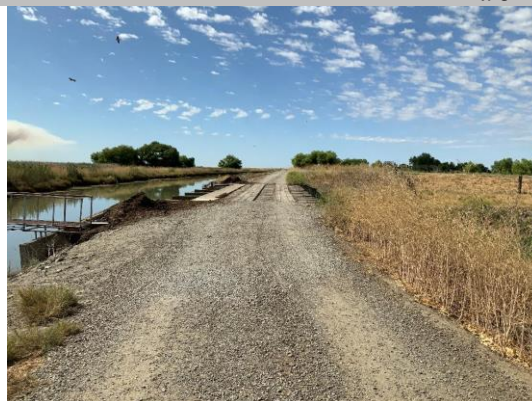
Photo 1 of 3 : UCIP\_FA\_2021\_69753\_103875.jpg

DS\_ID:19721  
FS\_ID:69753  
EP\_NO: N/A  
Repair Type: Non-Urgent  
EVAL Issue: Unauthorized Encroachment, installed decades prior  
Crossing Status: Found  
UCIP Comments: 06/09/2021 The record has been upgraded from No Action Needed to Non-Urgent. Structure is functioning and in good standing. No permit was found authorizing this encroachment. CVFPB will need to review crossing to determine owner. The UCIP inspection was completed with GEI staff, H.Dunn. (P.Espinoza – GEI)

View from levee crown.

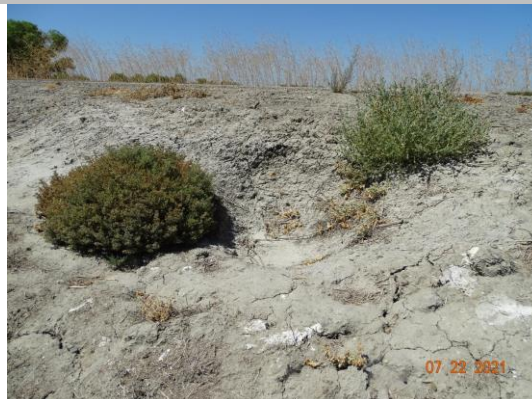
Photo 1 of 1 : FA\_2021\_NA0010\_138\_22\_20211025\_00047.jpg

LM Start	1.04	Rating **	M	Issue No.	22
LM End	1.04	Issue Type +	Ma	Location *	WS
Category	Earthen Levee			GPS Latitude/Longitude	
				Start	End
Item	Slope Stability			37.220281 °	37.220281 °
				-120.698287 °	-120.698287 °
DWR ID	DWR_NA0010_22A_f_2021_22				
Comment Code					
S1 : Repair slope instability.					
Inspector Comment

View of the erosion pocket on the levee slope (Fall 2021).

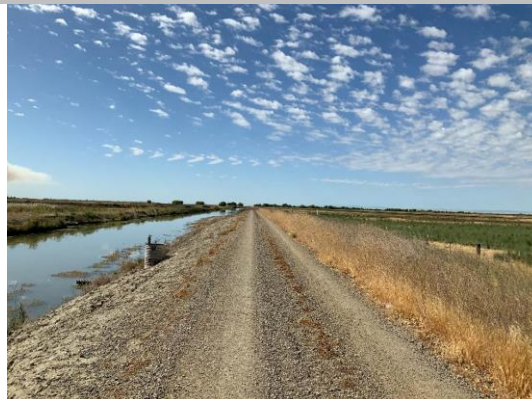
Photo 1 of 3 : UCIP\_FA\_2021\_69880\_103899.jpg

DS\_ID:19936  
FS\_ID:69880  
EP\_NO: N/A  
Repair Type: Non-Urgent  
EVAL Issue: Safety Issue  
Crossing Status: Found  
UCIP Comments: 06/09/2021 The record remains Non-Urgent. Appears abandoned due to headwall not being found on LS. (CMP) riser has no lid, causing a safety hazard; debris visible inside riser, recommend clearing out unless confirmed abandoned. Limited inspection on WS due to water and on LS due to dense vegetation, recommend removal of LS vegetation. No permit was found authorizing this encroachment. CVFPB will need to review crossing to determine owner. The UCIP inspection was completed with GEI staff, H.Dunn. (P.Espinoza – GEI)

04/15/2014 Slide gate rusted and does not function. Headwall buried at LS toe. Pipe appears abandoned and if so should be done so properly. (W. Wylie - DWR UCIP)  
FIELD\_STRUCT\_DESC: 8-inch corrugated metal gravity irrigation pipe through the levee, 7 feet below the crown. Slide gate in a 36-inch corrugated metal pipe (CMP) riser on the waterside (WS) slope. Concrete headwall on the landside (LS) end. [Additional Reference(s): DWR Levee Log, 2002 (HLM 1.57), listed as a 8-inch corrugated metal pipe (CMP). USACE San Joaquin O&M Manual, Unit 601 Part 1 (SJR601.1), 1967, Revised 25 May 2011, (HLM 1.57), listed as a 8-inch CMP]  
FS Date: 6/9/2021 2:54:00 PM

View from levee crown.

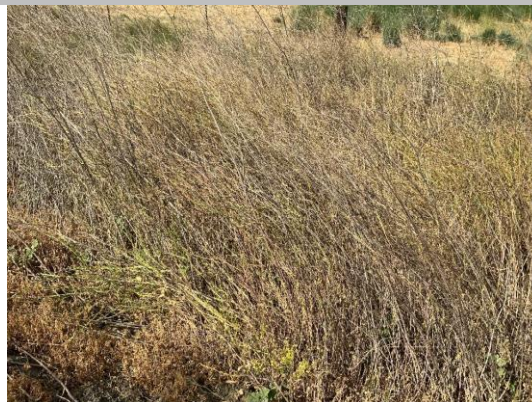
Photo 2 of 3 : UCIP\_FA\_2021\_69880\_103905.jpg

LS view: Slope from crown, dense vegetation.

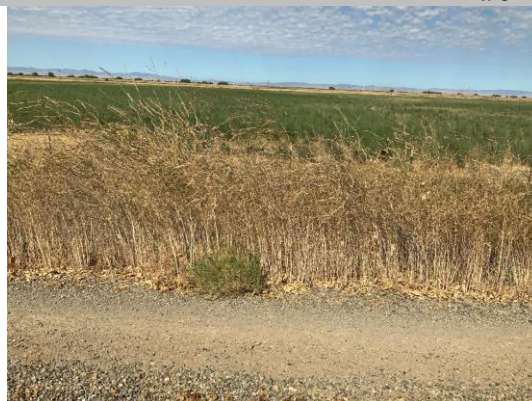
Photo 3 of 3 : UCIP\_FA\_2021\_69880\_103906.jpg

LS view: Toe from crown, dense vegetation.

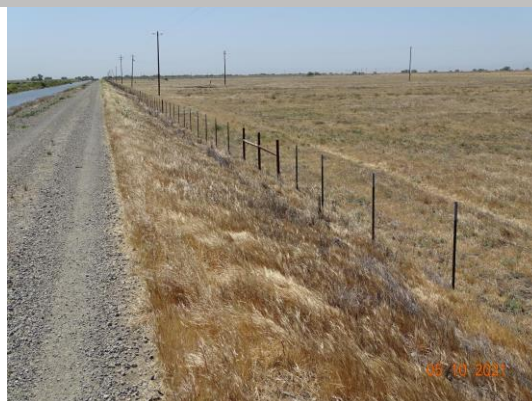
Photo 1 of 1 : FA\_2021\_NA0010\_138\_28\_20210830\_00027.jpg

LM Start	1.75	Rating **	M	Issue No.	28
LM End	2.60	Issue Type +	En	Location *	LS
Category	Earthen Levee			GPS Latitude/Longitude	
				Start	End
Item	Encroachments			37.230585 °	37.242371 °
				-120.702045 °	-120.706371 °
DWR ID	DWR_NA0010_22A_f_2018_28				
Comment Code					
FE : Fence					
Inspector Comment					
A fence is located along the landside toe.

View of fence along landside toe. (Spring 2021)

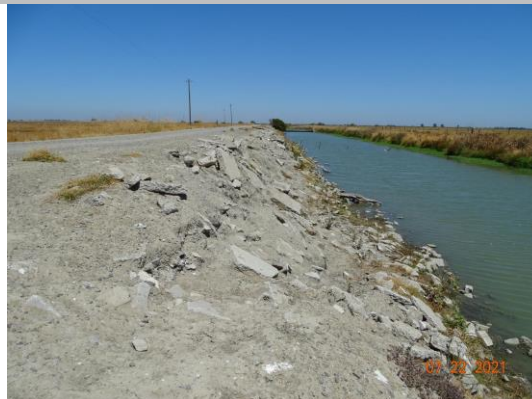
Photo 1 of 2 : SJR2021\_NA0010U22RM3.87\_1.JPG

07/22/2021: The erosion length was updated to 50 ft based on more accurate field measurements. Otherwise, no significant changes were observed since the previous inspection.

08/18/2020: The site has been covered with loose fill and crushed concrete pieces. The erosion will likely worsen again during the next high water.

09/12/2019: The erosion has cut into the levee prism and damaged almost half of the levee. The livestock traffic has likely caused the erosion.

7/22/2021: View of the erosion with fill and concrete looking downstream.

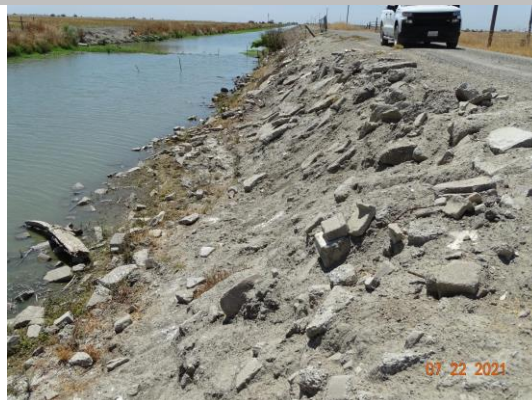
Photo 2 of 2 : SJR2021\_NA0010U22RM3.87\_3.JPG

8/18/2020: Close-up view of the erosion.

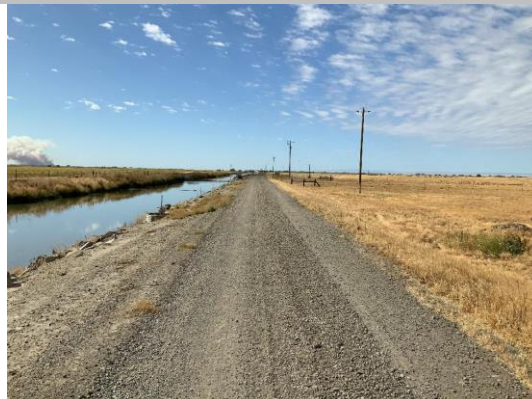
Photo 1 of 3 : UCIP\_FA\_2021\_69883\_103907.jpg

DS\_ID:19937  
FS\_ID:69883  
EP\_NO: N/A  
Repair Type: Non-Urgent  
EVAL Issue: Safety Issue  
Crossing Status: Found  
UCIP Comments: 06/09/2021 The record remains Non-Urgent. Appears abandoned due to no found headwall on LS toe. (CMP) riser missing lid, causing a safety hazard. Slidegate appears to be open; visible water in CMP riser. Limited inspection of WS inlet due to it being underwater at the time of survey. No permit was found authorizing this encroachment. CVFPB will need to review crossing to determine owner. The UCIP inspection was completed with GEI staff, H.Dunn.  
(P.Espinoza – GEI) 04/15/2014 Slide gate does not function and should be repaired. Headwall at LS toe not found. (W. Wylie - DWR UCIP)  
FIELD\_STRUCT\_DESC: 24-inch corrugated metal irrigation siphon pipe through the levee, 7.5 feet below the crown. Slide gate in a 36-inch corrugated metal pipe (CMP) riser on the waterside (WS) slope. Concrete U-shaped headwall on the landside (LS) end. [Additional Reference(s): DWR Levee Log, 2002 (HLM 2.72), listed as a 24-inch corrugated metal pipe (CMP). USACE San Joaquin O&M Manual, Unit 601 Part 1 (SJR601.1), 1967, Revised 25 May 2011, (HLM 2.72), listed as a 24-inch CMP].

View from levee crown.

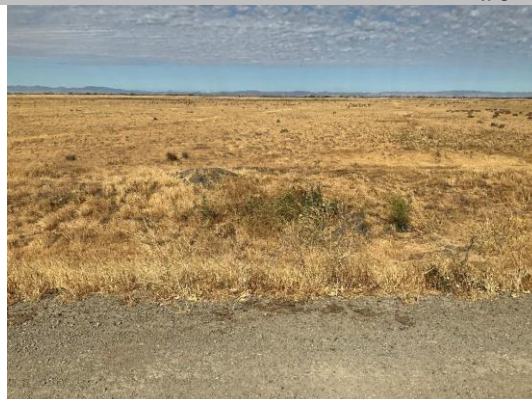
Photo 2 of 3 : UCIP\_FA\_2021\_69883\_103909.jpg

LS view: Toe from crown, no headwall visible.

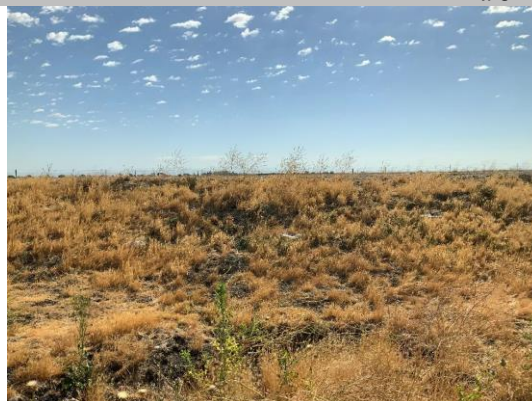
Photo 3 of 3 : UCIP\_FA\_2021\_69883\_103914.jpg

LS view: Slope from toe, no headwall visible.

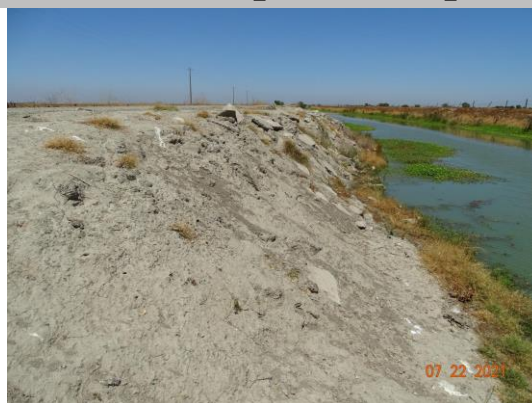
Photo 1 of 2 : SJR2021\_NA0010U22RM3.7\_1.JPG

07/22/2021: From 2020 to present, no significant changes were observed during the annual survey. In some areas, the levee shoulder width is up to 8 ft. There is some crushed concrete on the levee slope. 09/12/2019: The erosion has damaged entire levee slope. The livestock traffic likely has caused the erosion.

7/22/2021: View of the erosion looking downstream.

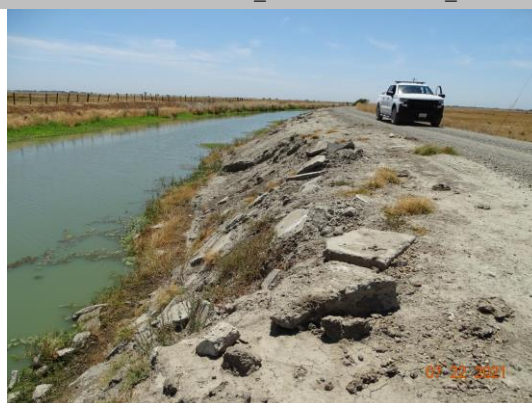
Photo 2 of 2 : SJR2021\_NA0010U22RM3.7\_3.JPG

7/22/2021: View of the eroded levee slope looking upstream.

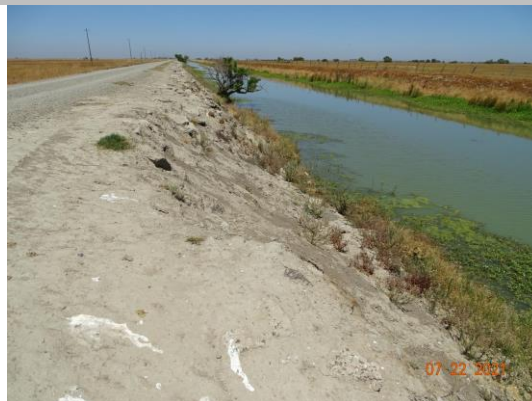
Photo 1 of 2 : SJR2021\_NA0010U22RM3.65\_1.JPG

07/22/2021: No significant changes were observed since the previous inspection.

08/18/2020: No vegetation visible in the area of the erosion. Noticed some crushed concrete pieces on the levee slope and a small amount of loose fill.

09/12/2019: The erosion has damaged entire levee slope. The livestock traffic likely has caused the erosion.

7/22/2021: View of the erosion looking downstream.

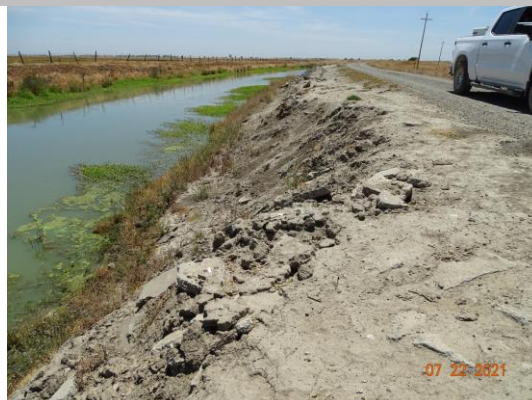
Photo 2 of 2 : SJR2021\_NA0010U22RM3.65\_2.JPG

7/22/2021: View of the erosion looking upstream.

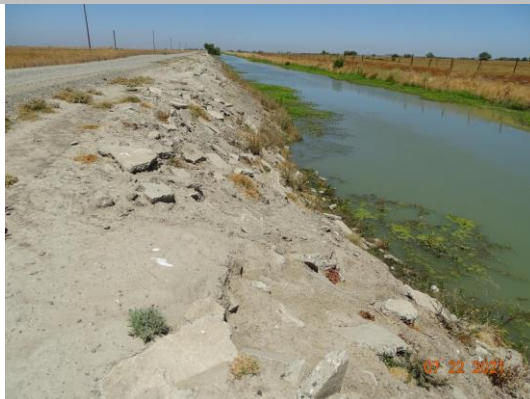
Photo 1 of 2 : SJR2021\_NA0010U22RM3.56\_1.JPG

07/22/2021: No significant changes were observed since the previous inspection.

08/18/2020: The erosion has been covered with loose fill and crushed concrete pieces. A nearly vertical slope remains at the levee toe in some sections. The site will likely worsen again during the next high water.

09/12/2019: The erosion has damaged entire levee slope. The livestock activity likely has caused the erosion.

7/22/2021: View of the erosion and crushed concrete on the slope.

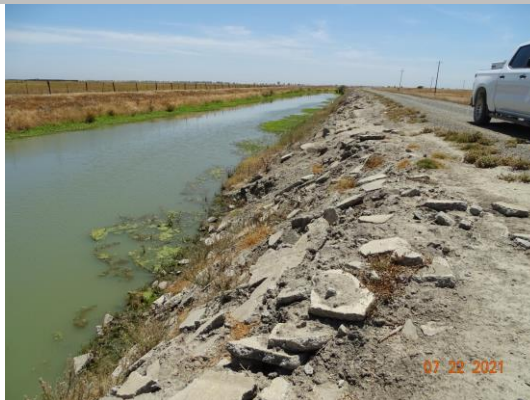
Photo 2 of 2 : SJR2021\_NA0010U22RM3.56\_2.JPG

7/22/2021: View of the erosion looking upstream.

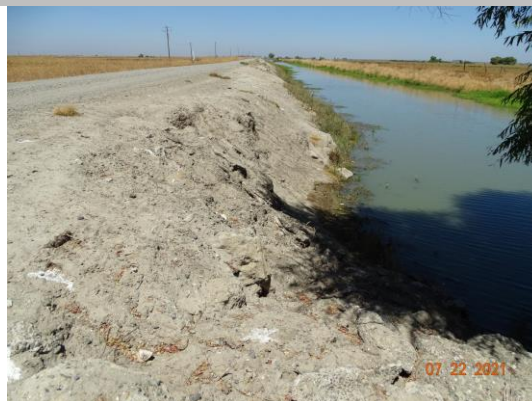
Photo 1 of 2 : SJR2021\_NA0010U22RM3.38\_1.JPG

07/22/2021: No significant changes were observed since the previous inspection.

09/12/2019: The erosion has damaged the entire levee slope. Livestock activity likely has caused the erosion.

7/22/2021: View of the erosion looking downstream.

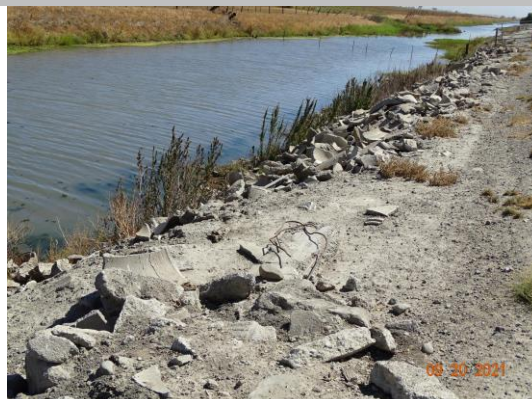
Photo 1 of 1 : FA\_2021\_NA0010\_138\_35\_20211008\_00044.jpg

LM Start	3.47	Rating **	U	Issue No.	35
LM End	3.47	Issue Type +	Ma	Location *	WS
Category	Earthen Levee			GPS Latitude/Longitude	
				Start	End
Item	Animal Control			37.251621 °	37.251621 °
				-120.715649 °	-120.715649 °
DWR ID	DWR_NA0010_22A_f_2018_35				
Comment Code					
A2 : Repair the levee slope damaged by livestock and prevent large animal access.					
Inspector Comment					
Waterside slope erosion is from livestock activity. Slope stabilized with broken concrete. Concrete with rebar in it should be removed.

Fill and concrete placed on the waterside slope. Rebar should be removed for safety. (Fall 2021)

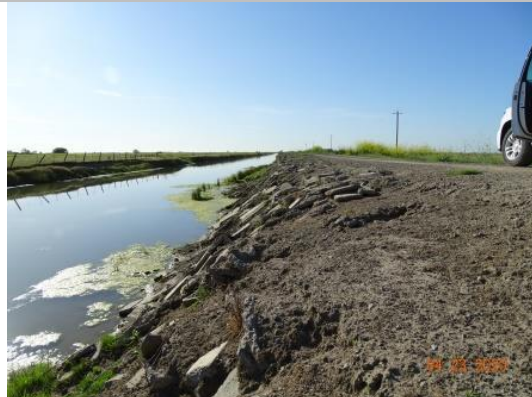
Photo 1 of 1 : FA\_2021\_NA0010\_138\_9\_20210830\_00016.jpg

LM Start	3.64	Rating **	A/W	Issue No.	9
LM End	3.69	Issue Type +	Ma	Location *	WS
Category	Earthen Levee			GPS Latitude/Longitude	
				Start	End
Item	Animal Control			37.253362 °	37.253862 °
				-120.717873 °	-120.718507 °
DWR ID	DWR_NA0010_22A_f_2016_9				
Comment Code					
A2 : Repair the levee slope damaged by livestock and prevent large animal access.					
Inspector Comment					
Broken concrete has been placed to limit further erosion caused by livestock. Monitor.

View of waterside slope looking upstream. (Spring 2020)

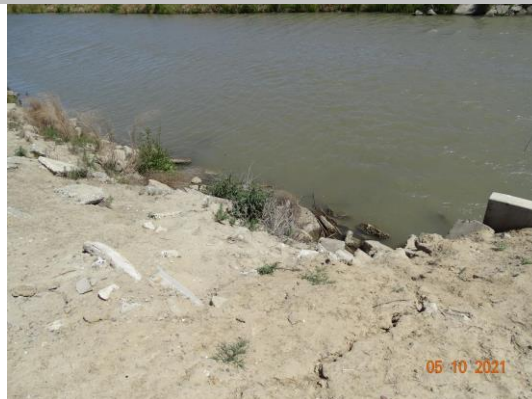
Photo 1 of 1 : FA\_2021\_NA0010\_138\_14\_20210830\_00024.jpg

LM Start	3.82	Rating **	M	Issue No.	14
LM End	3.82	Issue Type +	Ma	Location *	WS
Category	Earthen Levee			GPS Latitude/Longitude	
				Start	End
Item	Slope Stability			37.255239 °	37.255239 °
				-120.720142 °	-120.720142 °
DWR ID	DWR_NA0010_22A_f_2017_14				
Comment Code					
S1 : Repair slope instability.					
Inspector Comment					
Broken concrete previously placed to stabilize the slope has washed out.

Damage to the waterside slope. (Spring 2021)

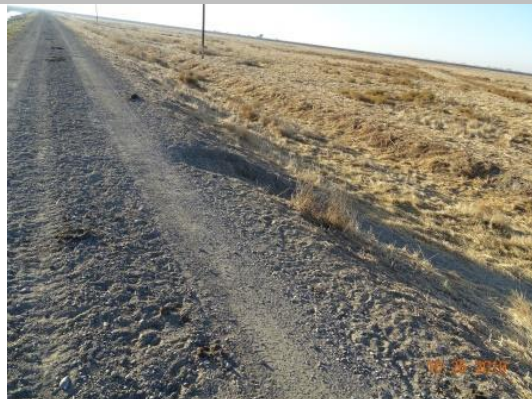
Photo 1 of 1 : FA\_2021\_NA0010\_138\_15\_20210830\_00025.jpg

LM Start	4.11	Rating **	M	Issue No.	15
LM End	4.11	Issue Type +	Ma	Location *	LS
Category	Earthen Levee			GPS Latitude/Longitude	
				Start	End
Item	Animal Control			37.258353 °	37.258353 °
				-120.723824 °	-120.723824 °
DWR ID	DWR_NA0010_22A_f_2019_15				
Comment Code					
A2 : Repair the levee slope damaged by livestock and prevent large animal access.					
Inspector Comment

View of erosion in the landside slope and shoulder from livestock traffic. (Fall 2019)

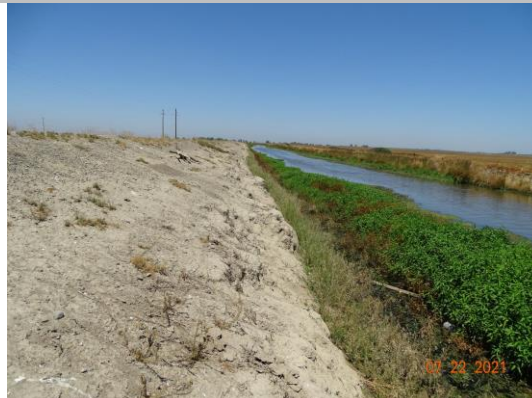
Photo 1 of 2 : SJR2021\_NA0010U22RM2.25\_1.JPG

LM Start	4.26	Rating **	U	Issue No.	10
LM End	4.30	Issue Type +	Ma	Location *	
Category	Supplemental			GPS Latitude/Longitude	
				Start	End
Item	DWR Erosion Survey			37.260111 °	37.260111 °
				-120.725900 °	-120.725900 °
DWR ID	NA0010U22RM2.25				
Comment Code					
Inspector Comment					
Site ID: NA0010U22RM2.25					
07/22/2021: From 2020 to present, no significant changes were observed during the annual survey.					
09/12/2019: Erosion has developed into the lower levee slope. Loose material was observed at the site.

7/22/2021: View of the erosion looking downstream.

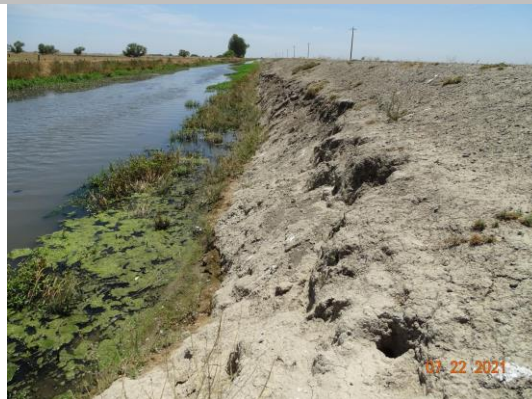
Photo 2 of 2 : SJR2021\_NA0010U22RM2.25\_5.JPG

7/22/2021: Close-up view of the erosion looking upstream.

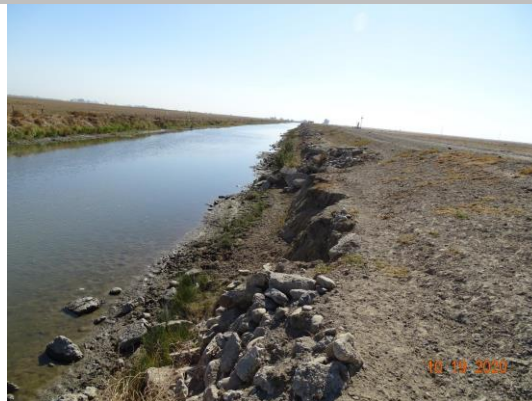
Photo 1 of 1 : FA\_2021\_NA0010\_138\_37\_20210830\_00031.jpg

LM Start	4.30	Rating **	U	Issue No.	37
LM End	5.11	Issue Type +	Ma	Location *	WS
Category	Earthen Levee			GPS Latitude/Longitude	
				Start	End
Item	Erosion / Bank Caving			37.260111 °	37.268135 °
				-120.725900 °	-120.737130 °
DWR ID	DWR_NA0010_22A_f_2018_37				
Comment Code					
E2 : Schedule repair of erosion site prior to the next inspection.					
Inspector Comment					
Erosion is cutting into the waterside slope. Some sections have been stabilized with cobble stone and broken concrete.

View of waterside slope damage looking upstream. (Fall 2020)

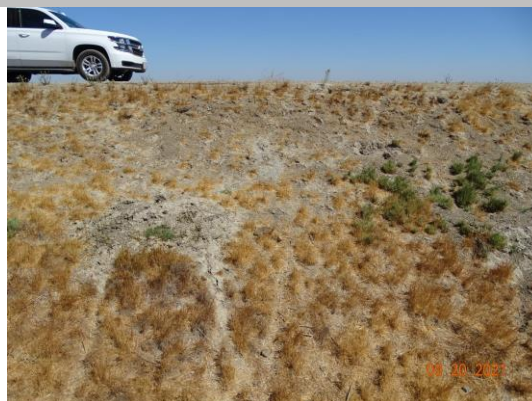
Photo 1 of 1 : FA\_2021\_NA0010\_138\_21\_20211008\_00045.jpg

LM Start	4.42	Rating **	M	Issue No.	21
LM End	4.42	Issue Type +	Ma	Location *	LS
Category	Earthen Levee			GPS Latitude/Longitude	
				Start	End
Item	Animal Control			37.261573 °	37.261573 °
				-120.727622 °	-120.727622 °
DWR ID	DWR_NA0010_22A_f _ 2021_21				
Comment Code					
A3 : No rodents visible, but rodent burrows visible; need to backfill and compact or grout burrows.					
Inspector Comment					
District has placed a bait station at the location.

View of displaced earth and rodent holes in the landside slope. (Fall 2021)

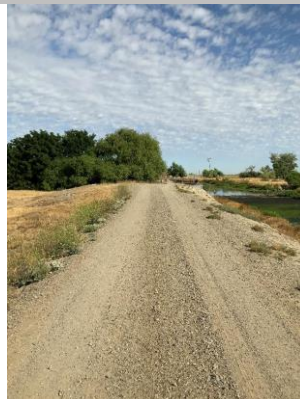
Photo 1 of 3 : UCIP\_FA\_2021\_69884\_103915.jpg

DS\_ID:19938  
FS\_ID:69884  
EP\_NO: N/A  
Repair Type: Non-Urgent  
EVAL Issue: Limited Inspection/No UCIP Evaluation  
Crossing Status: Found  
UCIP Comments: 06/09/2021 The record remains Non-Urgent. Appears abandoned due to the LS headwall being buried in sediment and debris buildup, recommend clearing out. Inlet pipe on WS is not visible due to water in channel at the time of the survey. Limited inspection on both WS and LS pipe inlet/outlet. No permit was found authorizing this encroachment. CVFPB will need to review crossing to determine owner. The UCIP inspection was completed with GEI staff, H.Dunn.  
(P.Espinoza – GEI) 04/15/2014 Need to contact owner. Pipe silted in on LS toe. Appears abandoned and if so should be done so properly.

View of levee crown.

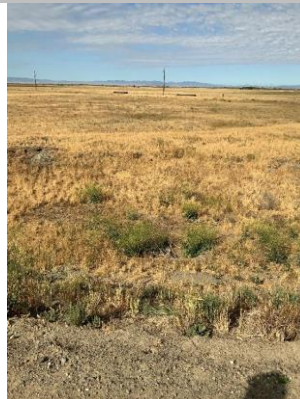
Photo 2 of 3 : UCIP\_FA\_2021\_69884\_103916.jpg

LS view: Toe from crown.

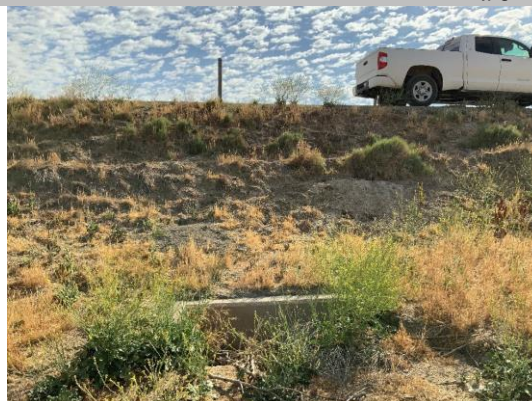
Photo 3 of 3 : UCIP\_FA\_2021\_69884\_103919.jpg

LS view: slope and buried headwall at toe.

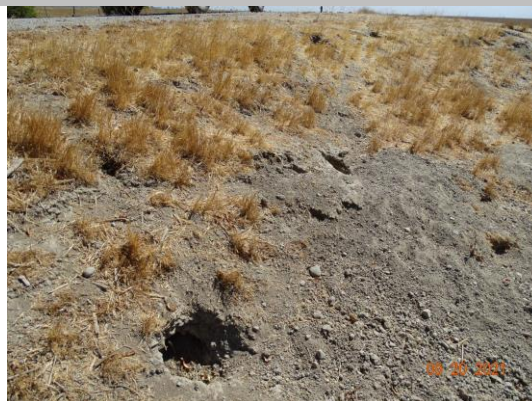
Photo 1 of 1 : FA\_2021\_NA0010\_138\_20\_20211008\_00046.jpg

LM Start	5.50	Rating **	M	Issue No.	20
LM End	5.50	Issue Type +	Ma	Location *	LS
Category	Earthen Levee			GPS Latitude/Longitude	
				Start	End
Item	Animal Control			37.272345 °	37.272345 °
				-120.741883 °	-120.741883 °
DWR ID	DWR_NA0010_22A_f_2021_20				
Comment Code					
A3 : No rodents visible, but rodent burrows visible; need to backfill and compact or grout burrows.					
Inspector Comment

View of rodent holes in the landside slope looking upstream. (Fall 2021)

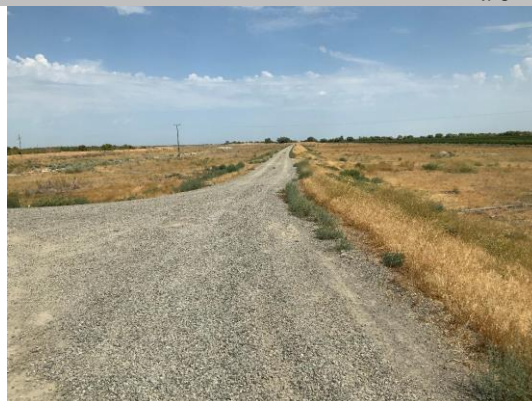
Photo 1 of 3 : UCIP\_FA\_2021\_68585\_102569.jpg

DS\_ID:19944  
FS\_ID:68585  
EP\_NO: N/A  
Repair Type: Non-Urgent  
EVAL Issue: Pipe Not Found  
Crossing Status: Not Found  
UCIP Comments: 07/19/2021 The record has been upgraded from No Action Needed to Non-Urgent. Pipe not found by visual inspection. No permit was found authorizing this encroachment. CVFPB will need to review crossing to determine owner. Pile of small pipes seen on LS toe, possibly removed pipe from this DSID, contact owner to confirm status of pipe. The UCIP inspection was completed with GEI staff, P. Espinoza. (H. Dunn ? GEI)  
FIELD\_STRUCT\_DESC: Underground telephone conduit of an unknown size or material at the centerline of the roadway, at an unknown depth. Provide a field description of this crossing. [Additional Reference(s): DWR Levee Log, 2002 (HLM 0.00), listed as an underground telephone cable].  
FS Date: 7/19/2021

Levee crown.

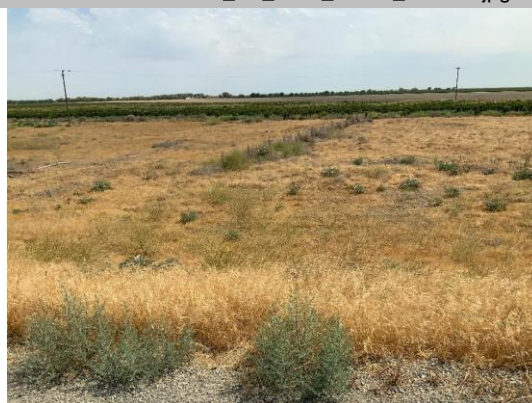
Photo 2 of 3 : UCIP\_FA\_2021\_68585\_102571.jpg

LS view: Toe from crown, no pipe visible.

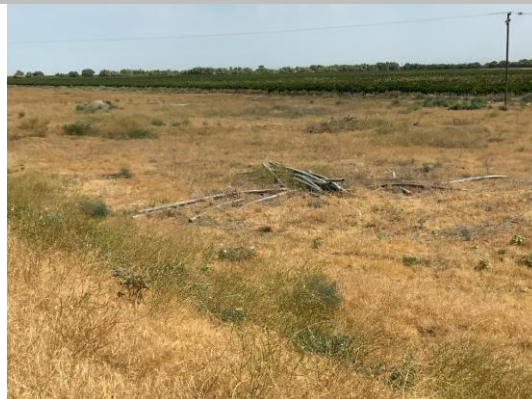
Photo 3 of 3 : UCIP\_FA\_2021\_68585\_102572.jpg

LS view: Pile of discarded pipe off the toe from crown.

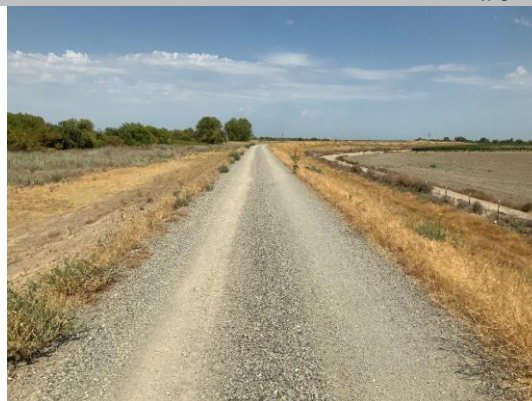
Photo 1 of 3 : UCIP\_FA\_2021\_68586\_102573.jpg

DS\_ID:19945  
 FS\_ID:68586  
 EP\_NO: N/A  
 Repair Type: Non-Urgent  
 EVAL Issue: Limited Inspection/No UCIP Evaluation  
 Crossing Status: Found  
 UCIP Comments: 07/19/2021 The record remains Non-Urgent. Dense LS vegetation over pipe inlet, recommend removal. No permit was found authorizing this encroachment. CVFPB will need to review crossing to determine owner. The UCIP inspection was completed with GEI staff, P. Espinoza. (H. Dunn – GEI) 04/03/2014 Excessive vegetation at inlet--recommend clearing. (W. Wylie - DWR UCIP)  
 FIELD\_STRUCT\_DESC: 30-inch by 30-inch square reinforced concrete box gravity drainage culvert through the levee, 13 feet below the crown. Flap gate on the waterside (WS) end. Concrete headwall on the landside (LS) end. Concrete U-shaped headwall on the WS end. (Plans to construct a new discharge structure and to rehabilitate one existing diversion structure to return intercepted seepage to the San Joaquin River authorized under Permit No. 13085, 1981 - Diener, Dry River Farms). [Additional Reference(s): DWR Levee Log, 2002 (HLM 0.21), listed as a 30-inch square reinforced concrete box culvert (RCBC). USACE San Joaquin O&M Manual, Unit 601 Part 1 (SJR601.1), 1967, Revised 25 May 2011, (HLM 0.21), listed as a 2.5-foot by 2.5-foot RCBC]

Levee crown.

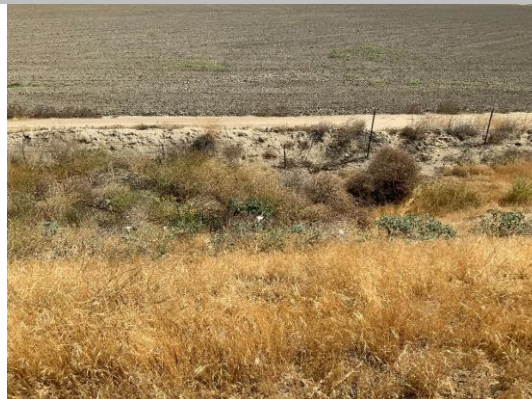
Photo 2 of 3 : UCIP\_FA\_2021\_68586\_102577.jpg

LS view: Toe from crown.

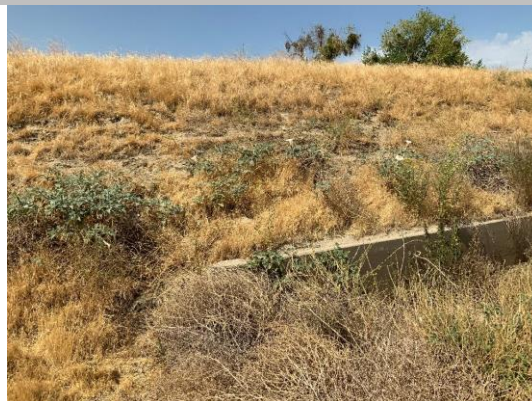
Photo 3 of 3 : UCIP\_FA\_2021\_68586\_102578.jpg

LS view: Headwall and slope from toe.

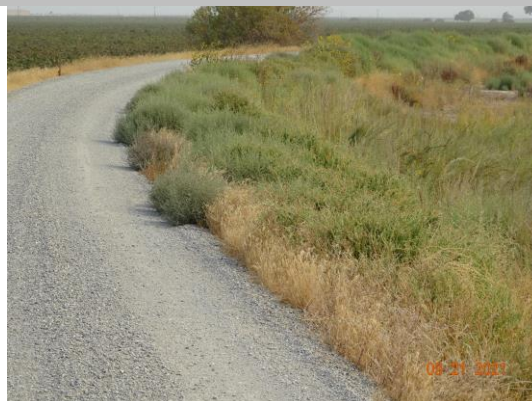
Photo 1 of 1 : FA\_2021\_NA0010\_139\_39\_20211008\_00063.jpg

LM Start	0.57	Rating **	U	Issue No.	39
LM End	0.82	Issue Type +	Ma	Location *	WS
Category	Earthen Levee			GPS Latitude/Longitude	
				Start	End
Item	Vegetation			36.774035 °	36.774073 °
				-120.275356 °	-120.271218 °
DWR ID	DWR_NA0010_23_f _ 2021_39				
Comment Code					
V1 : Control annual grass and weeds on the levee slopes and easements.					
Inspector Comment

Looking upstream along the waterside slope. (Fall 2021)

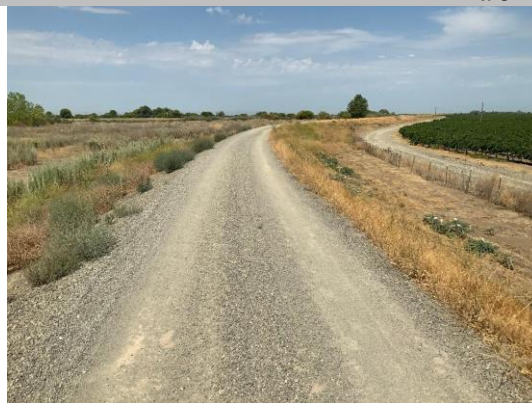
Photo 1 of 3 : UCIP\_FA\_2021\_68587\_102580.jpg

Comment Code						
Inspector Comment						
DS_ID:19946 FS_ID:68587 EP_NO: 13735 Repair Type: Non-Urgent EVAL Issue: Pipe Not Found Crossing Status: Not Found UCIP Comments: 07/19/2021 The record has been upgraded from No Action Needed to Non-Urgent. Pipe not found by visual inspection. DWR DMP geophysical study did not confirm presence of pipe through levee. Record will remain in UCIP's inspection records until future Levee Improvement Project can confirm no crossing was found through the levee. The UCIP inspection was completed with GEI staff, P. Espinoza. (H. Dunn – GEI) FIELD_STRUCT_DESC: 24-inch coated steel gravity drainage pipe through the levee, 2 feet below the crown. Steel cutoff wall at the center of the levee. Siphon breaker with protective housing on the apex of the pipe on the landside (LS) shoulder. Galvanized siphon vent pipe on the LS shoulder. Rock revetment on the waterside (WS) slope. Roadway padded over crossing. (Plans to install two 24-inch steel discharge pipelines through the levee to dispose of seepage water collected in farm sumps Nos. 8 and 12 authorized under Permit No. 13735, 1983 - Rio Seco Farm). [Additional Reference(s): DWR Levee Log, 2002 (HLM 1.07), listed as a 24-inch steel pipe]. FS Date: 7/19/2021

Levee crown.

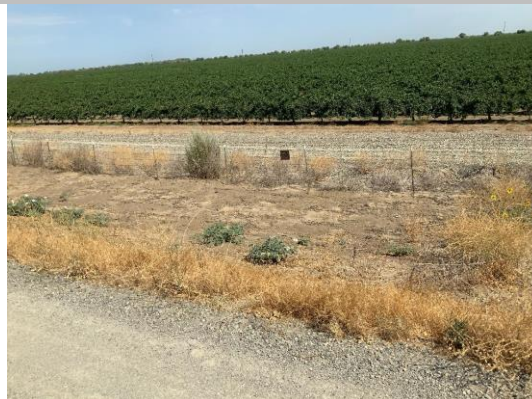
Photo 2 of 3 : UCIP\_FA\_2021\_68587\_102582.jpg

LS view: Toe from crown, no pipe visible.

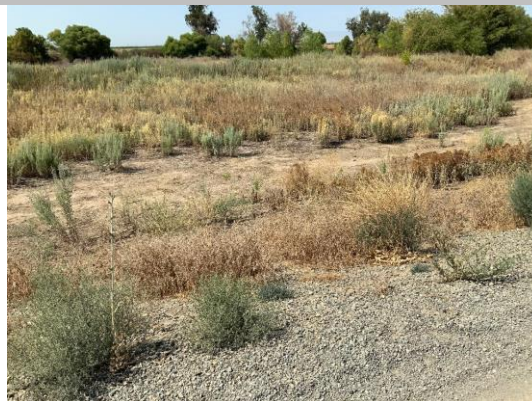
Photo 3 of 3 : UCIP\_FA\_2021\_68587\_102581.jpg

WS view: Toe from crown, no pipe visible.
