## Flood Control Project Maintenance Levee Inspections

### Fall 2021 Levee Maintenance Deficiency Summary Report

#### San Joaquin River Basin

NA0010 Lower San Joaquin Levee District	Overall LMA Rating	Total LMA Miles							
	U	191.27							
Rated Item	Maintenance Deficiency				Enforcement		Design & System Obsolescence		
	M Miles	U Miles	M + 4U Miles	Threshold %	M Miles	U Miles	M Miles	U Miles	
<i>Earthen Levee</i>									
Vegetation	47.00	9.57	85.28	44.59%					
Trim / Thin Trees	0.10		0.10	0.05%					
Encroachments	0.23	0.02	0.31	0.16%	9.29	0.59			
Animal Control	7.67	2.19	16.43	8.59%					
Slope Stability	0.05	0.01	0.09	0.05%					
Erosion / Bank Caving	0.13	0.81	3.37	1.76%					
Crown Surface / Depressions / Rutting	0.01		0.01	0.01%					
Repair Gates	0.02	0.02	0.10	0.05%					
<i>Rivers, Channels &amp; Designated Floodways</i>									
Encroachments					0.01	0.01			
<i>Supplemental</i>									
DWR Erosion Survey	0.12	0.17	0.80	0.42%					
DWR UCIP Field Study					1.29	0.05			
DWR UCIP LMA Responsibility									
<i>LMA Totals:</i>	55.33	12.79	106.49	55.67%	10.59	0.65	0.00	0.00

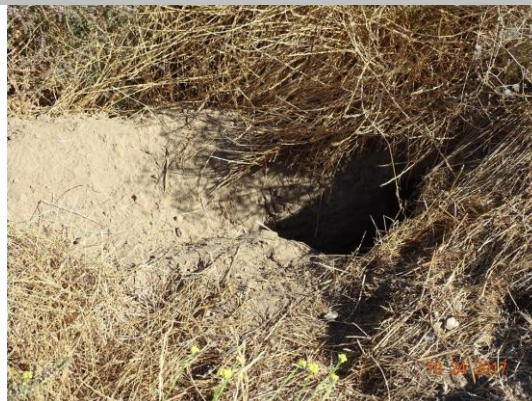
Photo 1 of 1 : FA\_2021\_NA0010\_139\_26\_20210830\_00006.jpg

LM Start	1.09	Rating **	M	Issue No.	26
LM End	1.09	Issue Type +	Ma	Location *	LS
Category	Earthen Levee			GPS Latitude/Longitude	
				Start	End
Item	Animal Control			36.772743 °	36.772743 °
				-120.266800 °	-120.266800 °
DWR ID	DWR_NA0010_23_f_2017_26				
Comment Code					
A3 : No rodents visible, but rodent burrows visible; need to backfill and compact or grout burrows.					
Inspector Comment					
Need to repair the large rodent hole on the landside slope.

Looking at the landside slope.

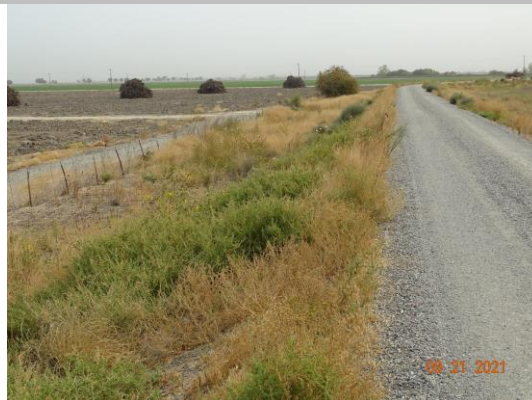
Photo 1 of 1 : FA\_2021\_NA0010\_139\_40\_20211008\_00064.jpg

LM Start	1.37	Rating **	M	Issue No.	40
LM End	2.20	Issue Type +	Ma	Location *	LS
Category	Earthen Levee			GPS Latitude/Longitude	
				Start	End
Item	Vegetation			36.773301 °	36.775702 °
				-120.261897 °	-120.250303 °
DWR ID	DWR_NA0010_23_f_2021_40				
Comment Code					
V1 : Control annual grass and weeds on the levee slopes and easements.					
Inspector Comment

View of vegetation growing on the landside slope. (Fall 2021)

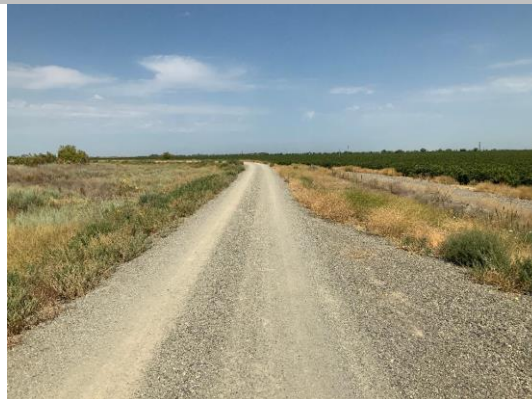
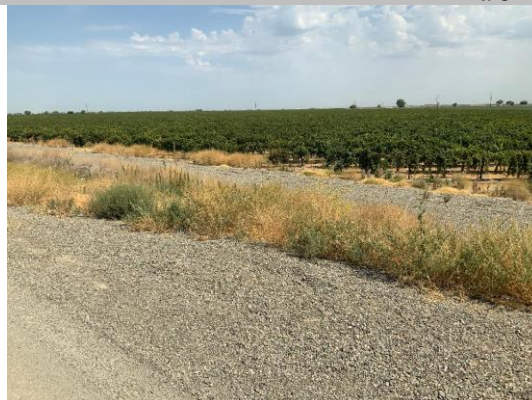
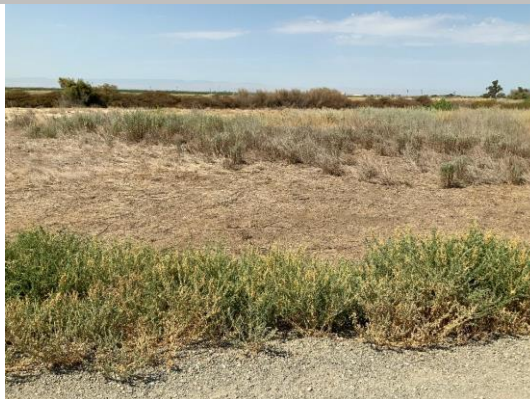
Comment Code						
Inspector Comment						
DS_ID:19947 FS_ID:68588 EP_NO: N/A Repair Type: Non-Urgent EVAL Issue: Pipe Not Found Crossing Status: Not Found UCIP Comments: 07/19/2021 The record has been upgraded from No Action Needed to Non-Urgent. Pipe not found by visual inspection. No permit was found authorizing this encroachment. CVFPB will need to review crossing to determine owner. The UCIP inspection was completed with GEI staff, P. Espinoza. (H. Dunn – GEI) FIELD_STRUCT_DESC: Telephone conduit of an unknown size or material under the levee crown, at an unknown depth. [Additional Reference(s): DWR Levee Log, 2002 (HLM 1.46), listed a a phone cable]. FS Date: 7/19/2021

Levee crown.

LS view: Toe from crown, no pipe or powerline visible.

WS view: Toe from crown, no pipe or powerline visible.

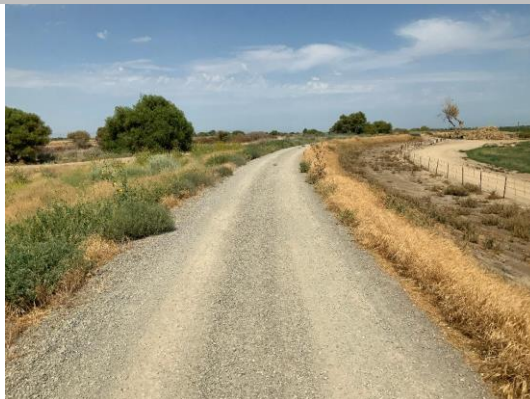
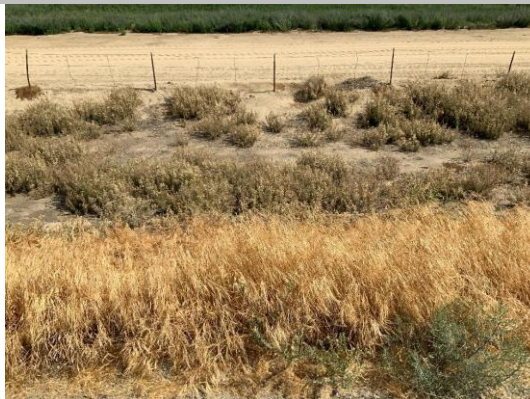
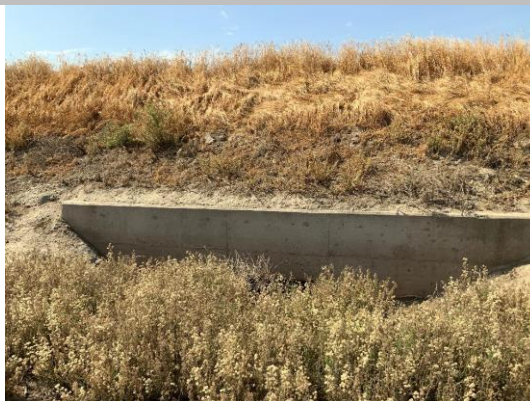
DS\_ID:19948  
 FS\_ID:68589  
 EP\_NO: N/A  
 Repair Type: Non-Urgent  
 EVAL Issue: Limited Inspection/No UCIP Evaluation  
 Crossing Status: Found  
 UCIP Comments: 07/19/2021 The record remains Non-Urgent.  
 Sediment buildup inside LS pipe inlet, recommend cleaning out. WS flapgate inaccessible due to barbed wire. No permit was found authorizing this encroachment. CVFPB will need to review crossing to determine owner. The UCIP inspection was completed with GEI staff, P. Espinoza. (H. Dunn – GEI) 04/03/2014 Appears abandoned and if so should be done properly. Discharge channel is blocked by sand and soil making drain ineffective. Soil buildup at inlet on LS toe. Need to contact owner. (W. Wylie - DWR UCIP)  
 FIELD\_STRUCT\_DESC: 30-inch by 30-inch square reinforced concrete box gravity drainage culvert through the levee, 11 feet below the crown. Flap gate on the waterside (WS) end. Concrete headwall on the landside (LS) end. Concrete U-shaped headwall on the WS end.

[Additional Reference(s): DWR Levee Log, 2002 (HLM 1.64), listed as a 30-inch square reinforced concrete box culvert [RCBC]].  
 FS Date: 7/19/2021

Levee crown.

LS view: Toe from crown.

LS view: Headwall and slope from toe.

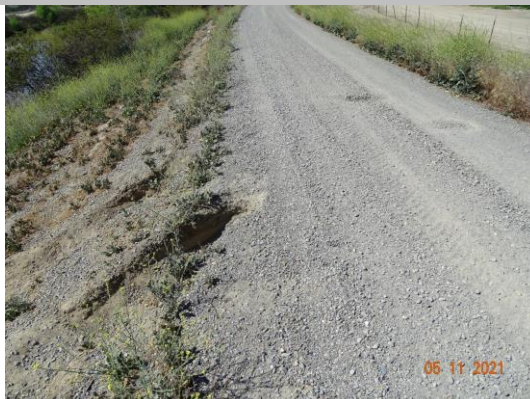
Photo 1 of 1 : FA\_2021\_NA0010\_139\_28\_20210830\_00007.jpg

LM Start	1.90	Rating **	U	Issue No.	28
LM End	1.90	Issue Type +	Ma	Location *	WS
Category	Earthen Levee			GPS Latitude/Longitude	
				Start	End
Item	Slope Stability			36.772731 °	36.772731 °
				-120.253590 °	-120.253590 °
DWR ID	DWR_NA0010_23_s_2021_28				
Comment Code					
S3 : Repair the levee slope damaged by vehicle traffic and prevent access where possible.					
Inspector Comment

View of damage to the waterside slope and shoulder. (Spring 2021)

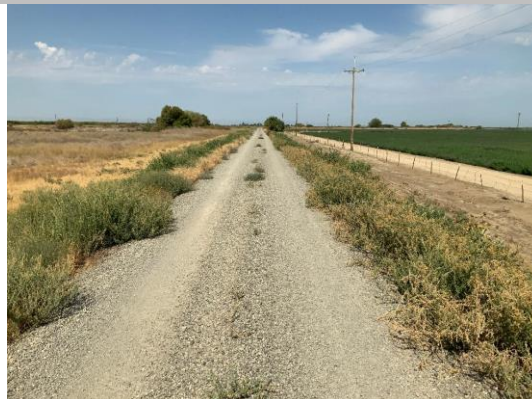
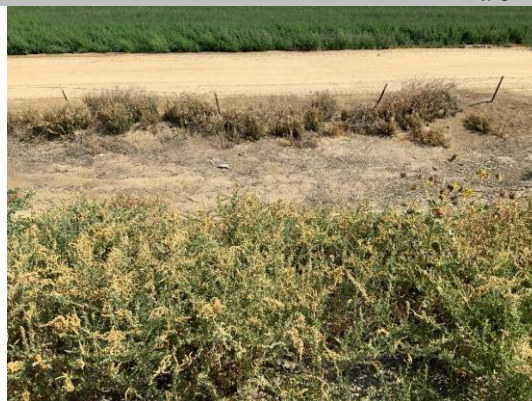
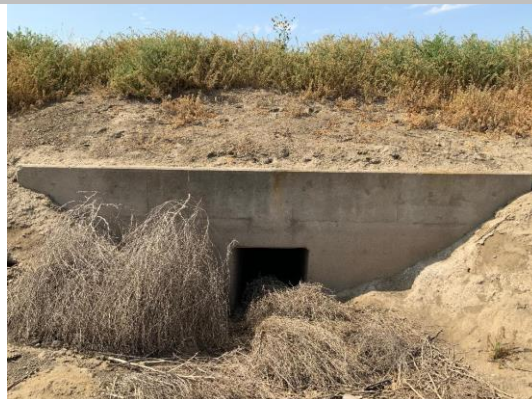
Comment Code						
Inspector Comment						
DS_ID:19951 FS_ID:68590 EP_NO: N/A Repair Type: Non-Urgent EVAL Issue: Maintenance Compliance Issue Crossing Status: Found UCIP Comments: 07/19/2021 The record has been upgraded from No Action Needed to Non-Urgent. Sediment and tumbleweed buildup over and inside LS pipe inlet, recommend removal. No permit was found authorizing this encroachment. CVFPB will need to review crossing to determine owner. The UCIP inspection was completed with GEI staff, P. Espinoza. (H. Dunn – GEI) FIELD_STRUCT_DESC: 30-inch by 30-inch square reinforced concrete box gravity drainage culvert through the levee, 9 feet below the crown. Flap gate on the waterside (WS) end. Concrete headwall on the landside (LS) end. Concrete U-shaped headwall on the WS end. [Additional Reference(s): DWR Levee Log, 2002 (HLM 2.99), listed as a 30-inch reinforced concrete box culvert (RCBC)]. FS Date: 7/19/2021

Levee crown.

LS view: Toe from crown.

LS view: Headwall and slope from toe.

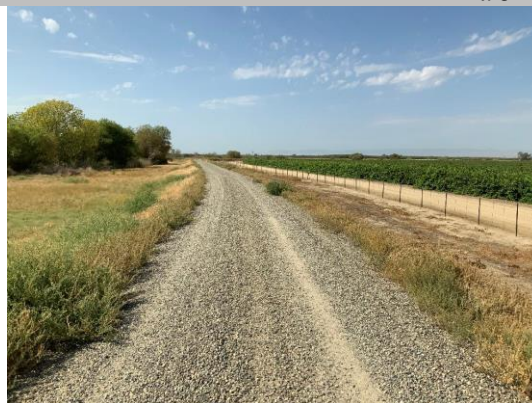
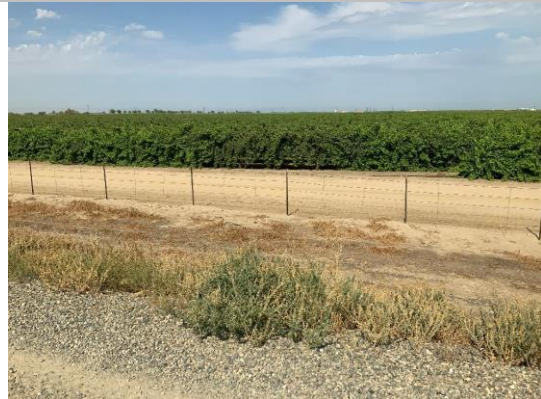
Comment Code						
Inspector Comment						
DS_ID:19952 FS_ID:68783 EP_NO: N/A Repair Type: Non-Urgent EVAL Issue: Safety Issue Crossing Status: Not Found UCIP Comments: 07/19/2021 The record remains Non-Urgent. Pipe not found by visual inspection. As a safety measure, need to coordinate with owner to determine status of line and to obtain maintenance and inspection records to confirm integrity of line through the levee or abandonment. No permit was found authorizing this encroachment. CVFPB will need to review crossing to determine owner. The UCIP inspection was completed with GEI staff, P. Espinoza. (H. Dunn – GEI)  04/03/2014 Verify abandonment with gas company. Need to contact owner to determine status of crossing. Need date of last inspection and confirmation that crossing is still in operable condition. (W. Wylie - DWR UCIP) FIELD_STRUCT_DESC: 4-inch natural gas pipeline of an unknown material through the levee, 6 feet below the crown. Gas line gaging area and compressor station in the channel, 50 feet from the waterside (WS) toe. [Additional Reference(s): DWR Levee Log, 2002 (HLM 4.72), listed as a 4-inch gas line] FS Date: 7/19/2021

Levee crown.

LS view: Toe from crown, no pipe or markers visible.

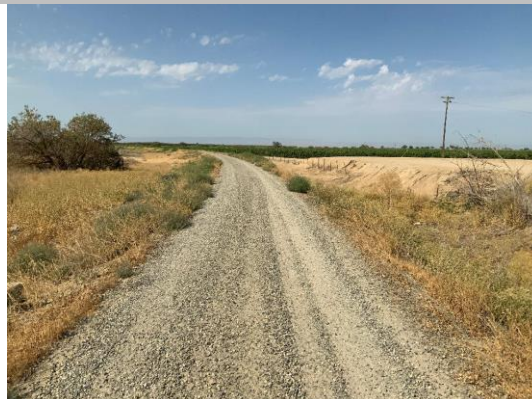
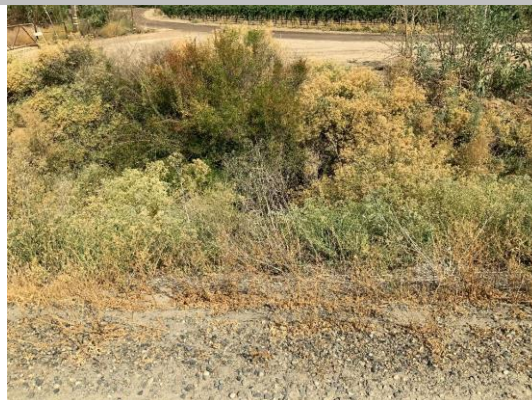
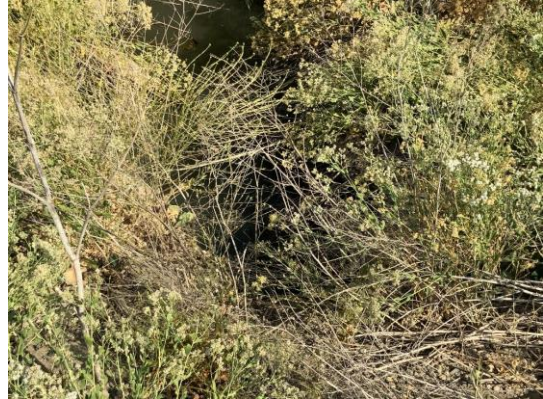
Comment Code					
Inspector Comment					
DS_ID:19953 FS_ID:68909 EP_NO: N/A Repair Type: Non-Urgent EVAL Issue: Limited Inspection/No UCIP Evaluation Crossing Status: Found UCIP Comments: 07/19/2021 The record remains Non-Urgent. WS pipe inlet underwater during inspection. LS pipe outlet not visible due to dense vegetation, recommend removing vegetation. Limited inspection on both WS and LS ends. No permit was found authorizing this encroachment. CVFPB will need to review crossing to determine owner. The UCIP inspection was completed with GEI staff, P. Espinoza. (H. Dunn – GEI) 04/03/2014 Heavy vegetation at inlet and outlet– recommend clearing. (W. Wylie - DWR UCIP) FIELD_STRUCT_DESC: 30-inch by 30-inch square reinforced concrete box gravity irrigation culvert through the levee, 10.7 feet below the crown. 4.5-foot by 7-foot concrete riser with slide gate on the waterside (WS) slope. Concrete U-shaped headwall on each end. 15-foot-long cobble revetted inlet channel. [Additional Reference(s): DWR Levee Log, 2002 (HLM 4.87), listed as a 30-inch square reinforced concrete box culvert (RCBC)]. FS Date: 7/19/2021

Levee crown.

LS view: Toe from crown.

LS view: Pipe outlet covered by dense vegetation at toe.

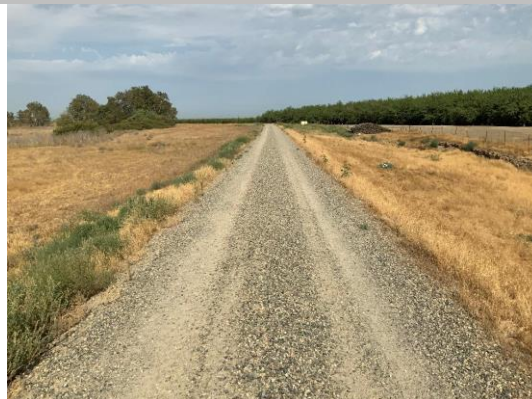
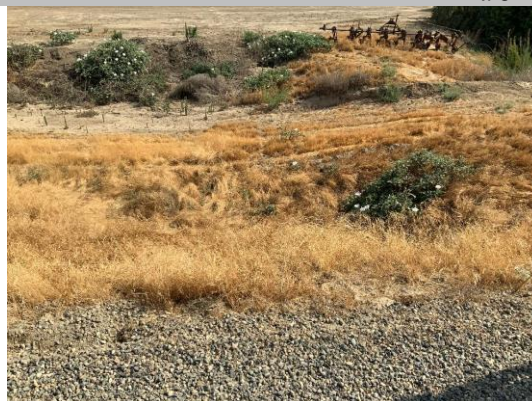
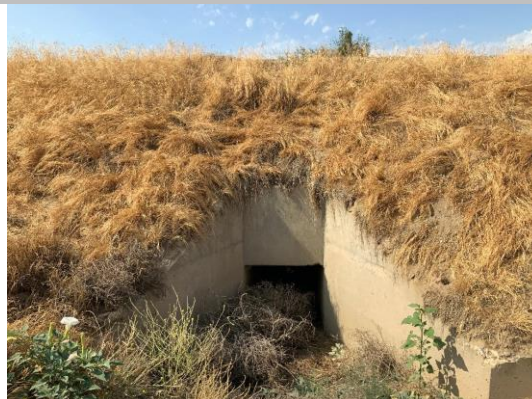
DS\_ID:19954  
FS\_ID:68602  
EP\_NO: N/A  
Repair Type: Non-Urgent  
EVAL Issue: Maintenance Compliance Issue  
Crossing Status: Found  
UCIP Comments: 07/19/2021 The record remains Non-Urgent. LS has sediment buildup in pipe inlet and buildup of tumbleweeds around pipe inlet, recommend clearing out. No permit was found authorizing this encroachment. CVFPB will need to review crossing to determine owner. The UCIP inspection was completed with GEI staff, P. Espinoza. (H. Dunn – GEI) 04/03/2014 Dense vegetation limits the inspector's visibility to identify signs of pipe failure (leaks) along the landward slope. Recommend removing vegetation along pipe alignment to conduct proper inspection of structure. (W. Wylie - DWR UCIP)  
FIELD\_STRUCT\_DESC: 36-inch by 36-inch square reinforced concrete box gravity drainage culvert through the levee, 9 feet below the crown. Flap gate on the waterside (WS) end. Concrete U-shaped headwall on each end. 5-foot-long cobble revetted outlet channel. [Additional Reference(s): DWR Levee Log, 2002 (HLM 5.71), listed as a 36-inch square reinforced concrete box culvert (RCBC). USACE San Joaquin O&M Manual, Unit 601 Part 1 (SJR601.1), 1967, Revised 25 May 2011, (HLM 5.71), listed as a 3-foot by 3-foot RCBC]].

Levee crown.

LS view: Toe from crown.

LS view: Headwall and slope from toe.

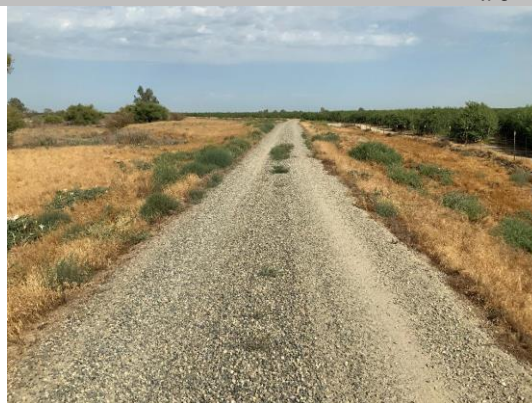
Photo 1 of 3 : UCIP\_FA\_2021\_68604\_102660.jpg

Comment Code						
Inspector Comment						
DS_ID:19939 FS_ID:68604 EP_NO: N/A Repair Type: Non-Urgent EVAL Issue: Maintenance Compliance Issue Crossing Status: Found UCIP Comments: 07/19/2021 The record remains Non-Urgent. LS pipe inlet almost completely filled with sediment, recommend removal. Water running through WS flapgate during inspection and wooden plank keeping WS flapgate closed, recommend removal before flood season for better flow. No permit was found authorizing this encroachment. CVFPB will need to review crossing to determine owner. The UCIP inspection was completed with GEI staff, P. Espinoza. (H. Dunn – GEI) 04/03/2014 Dense vegetation limits the inspector's visibility to identify signs of pipe failure (leaks) along the landward slope. Recommend removing vegetation along pipe alignment to conduct proper inspection of structure. (W. Wylie - DWR UCIP) FIELD_STRUCT_DESC: 30-inch by 30-inch square reinforced concrete box gravity drainage culvert through the levee, 8.5 feet below the crown. Flap gate on the waterside (WS) end. Concrete headwall on the landside (LS) end. Concrete U-shaped headwall on the WS end. [Additional Reference(s): DWR Levee Log, 2002 (HLM 7.06), listed as a 30-inch square reinforced concrete box culvert (RCBC)]. FS Date: 7/19/2021

Levee crown.

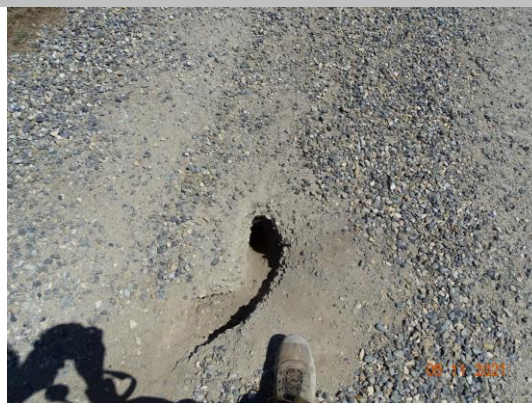
Photo 1 of 1 : FA\_2021\_NA0010\_139\_31\_20210830\_00009.jpg

LM Start	8.32	Rating **	M	Issue No.	31
LM End	8.32	Issue Type +	Ma	Location *	CR
Category	Earthen Levee			GPS Latitude/Longitude	
				Start	End
Item	Animal Control			36.792436 °	36.792436 °
				-120.181289 °	-120.181289 °
DWR ID	DWR_NA0010_23_s_2021_31				
Comment Code					
A3 : No rodents visible, but rodent burrows visible; need to backfill and compact or grout burrows.					
Inspector Comment

View of rodent burrow in the levee crown. (Spring 2021)

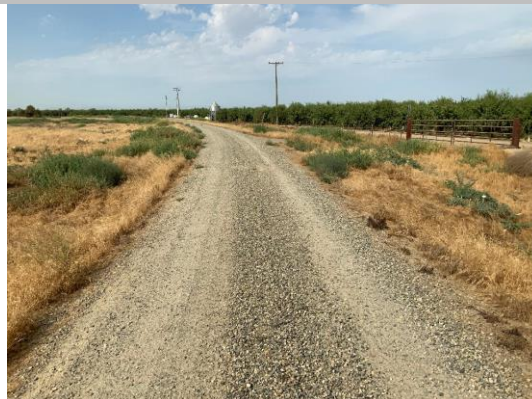
Photo 1 of 3 : UCIP\_FA\_2021\_68605\_102669.jpg

DS\_ID:19940  
FS\_ID:68605  
EP\_NO: N/A  
Repair Type: Non-Urgent  
EVAL Issue: Levee Damage or Threat for Levee Damage  
Crossing Status: Found  
UCIP Comments: 07/19/2021 The record remains Non-Urgent. LS pipe inlet almost complete covered by sediment, recommend clearing out. Some minor erosion along one side of the WS headwall as well as some burrow complexes on the slope adjacent to same headwall side. No permit was found authorizing this encroachment. CVFPB will need to review crossing to determine owner. The UCIP inspection was completed with GEI staff, P. Espinoza. (H. Dunn – GEI) 04/03/2014  
Some sediment buildup at inlet at LS toe. Also dense vegetation limits the inspector's visibility to identify signs of pipe failure (leaks) along the landward slope. Recommend removing vegetation along pipe alignment to conduct proper inspection of structure. (W. Wylie - DWR UCIP)  
FIELD\_STRUCT\_DESC: 30-inch by 30-inch square reinforced concrete box gravity drainage culvert through the levee, 5.2 feet below the crown. Flap gate on the waterside (WS) end. Concrete headwall on the landside (LS) end. Concrete U-shaped headwall on the WS end.

Levee crown.

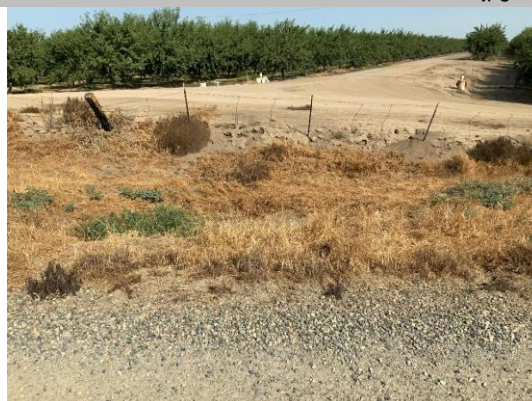
Photo 2 of 3 : UCIP\_FA\_2021\_68605\_102670.jpg

LS view: Toe from crown.

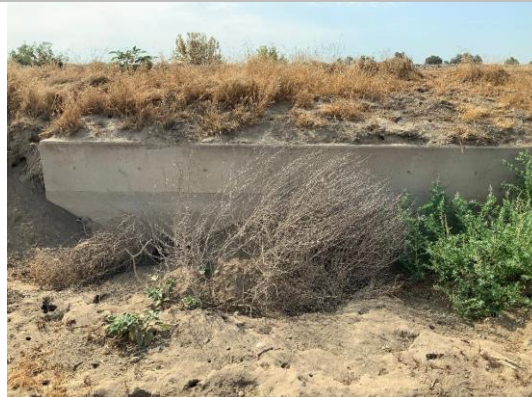
Photo 3 of 3 : UCIP\_FA\_2021\_68605\_102671.jpg

LS view: Headwall and slope from toe.

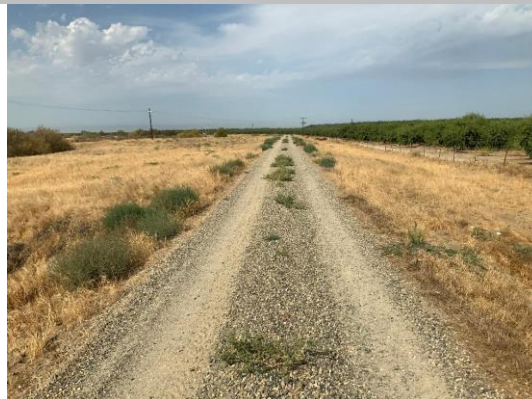
Photo 1 of 3 : UCIP\_FA\_2021\_68606\_102676.jpg

DS\_ID:19941  
 FS\_ID:68606  
 EP\_NO: N/A  
 Repair Type: Non-Urgent  
 EVAL Issue: Maintenance Compliance Issue  
 Crossing Status: Found  
 UCIP Comments: 07/19/2021 The record remains Non-Urgent. LS pipe inlet has sediment buildup inside, recommend removal. Extensive burrows above the LS headwall slope. No permit was found authorizing this encroachment. CVFPB will need to review crossing to determine owner. The UCIP inspection was completed with GEI staff, P. Espinoza. (H. Dunn – GEI) 04/03/2014 Dense vegetation limits the inspector's visibility to identify signs of pipe failure (leaks) along the landward slope. Recommend removing vegetation along pipe alignment to conduct proper inspection of structure. (W. Wylie - DWR UCIP)  
 FIELD\_STRUCT\_DESC: 30-inch by 30-inch square reinforced concrete box gravity drainage culvert through the levee, 5.6 feet below the crown. Flap gate on the waterside (WS) end. Concrete headwall on the landside (LS) end. Concrete U-shaped headwall on the WS end.

Levee crown.

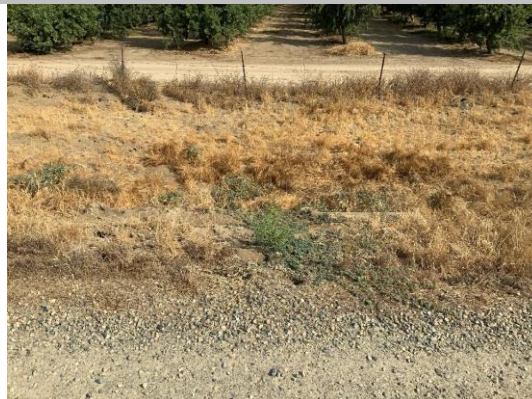
Photo 2 of 3 : UCIP\_FA\_2021\_68606\_102680.jpg

LS view: Toe from crown.

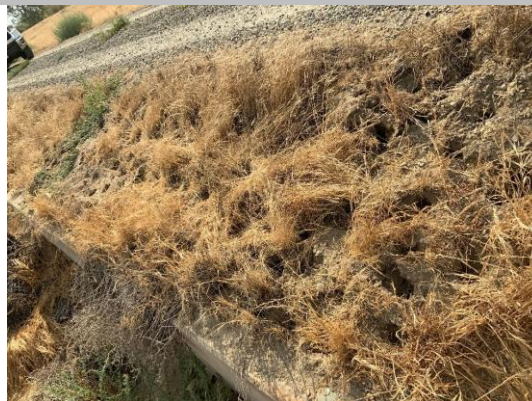
Photo 3 of 3 : UCIP\_FA\_2021\_68606\_102681.jpg

LS view: Burrow holes above headwall.

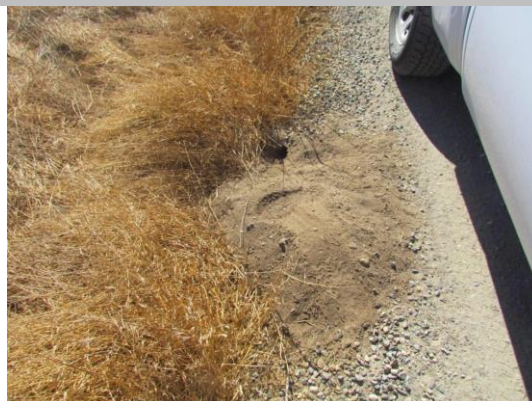
Photo 1 of 1 : FA\_2021\_NA0010\_139\_25\_20210830\_00005.jpg

LM Start	8.97	Rating **	M	Issue No.	25
LM End	8.97	Issue Type +	Ma	Location *	WS
Category	Earthen Levee			GPS Latitude/Longitude	
				Start	End
Item	Animal Control			36.799606 °	36.799606 °
				-120.175395 °	-120.175395 °
DWR ID	DWR_NA0010_23_f_2016_25				
Comment Code					
A3 : No rodents visible, but rodent burrows visible; need to backfill and compact or grout burrows.					
Inspector Comment					
There are rodent holes on the waterside shoulder.

Looking at typical view of rodent hole on waterward shoulder.

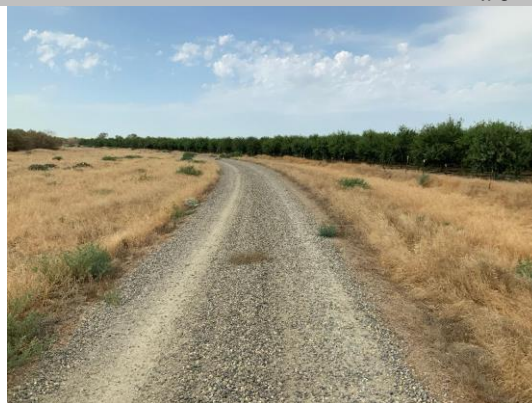
Photo 1 of 3 : UCIP\_FA\_2021\_68622\_102682.jpg

Comment Code					
Inspector Comment					
DS_ID:19560 FS_ID:68622 EP_NO: N/A Repair Type: Non-Urgent EVAL Issue: Pipe Not Found Crossing Status: Not Found UCIP Comments: 07/19/2021 The record has been upgraded from No Action Needed to Non-Urgent. Pipe not found by visual inspection. DWR DMP geophysical study did not confirm presence of pipe through levee. Record will remain in UCIP's inspection records until future Levee Improvement Project can confirm no crossing was found through the levee. No permit was found authorizing this encroachment. CVFPB will need to review crossing to determine owner. This portion of the levee has a levee prism less than 3 feet, appears to be high ground. The UCIP inspection was completed with GEI staff, P. Espinoza. (H. Dunn – GEI) FIELD_STRUCT_DESC: 16-inch steel gravity irrigation pipe through the levee, 2 feet below the crown. Well on the waterside (WS). [Additional Reference(s): USACE San Joaquin O&M Manual, Unit 601 Part 1 (SJR601.1), 1967, Revised 25 May 2011, (HLM 9.03), listed as a 16-inch steel pipe] FS Date: 7/19/2021

Levee crown.

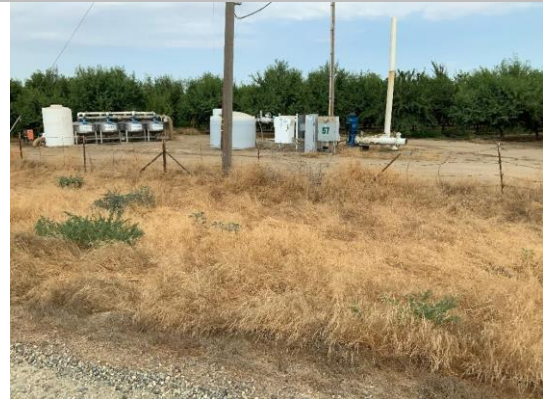
Photo 2 of 3 : UCIP\_FA\_2021\_68622\_102684.jpg

LS view: Toe from crown, no pipe visible.

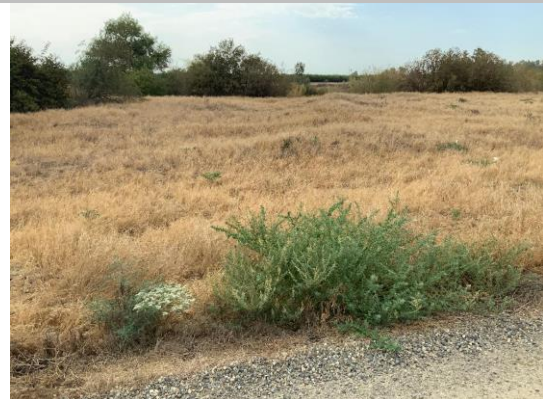
Photo 3 of 3 : UCIP\_FA\_2021\_68622\_102683.jpg

WS view: Toe from crown, no pipe visible.

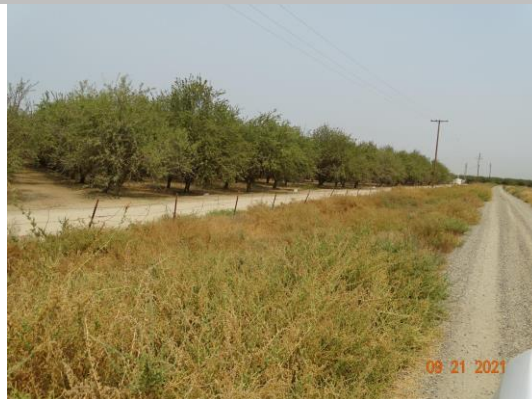
Photo 1 of 1 : FA\_2021\_NA0010\_139\_51\_20211008\_00066.jpg

LM Start	9.11	Rating **	U	Issue No.	51
LM End	9.47	Issue Type +	Ma	Location *	LS
Category	Earthen Levee			GPS Latitude/Longitude	
				Start	End
Item	Vegetation			36.801396 °	36.804262 °
				-120.174344 °	-120.169722 °
DWR ID	DWR_NA0010_23_f _ 2021_51				
Comment Code					
V1 : Control annual grass and weeds on the levee slopes and easements.					
Inspector Comment

Looking upstream along the landside slope. (Fall 2021)

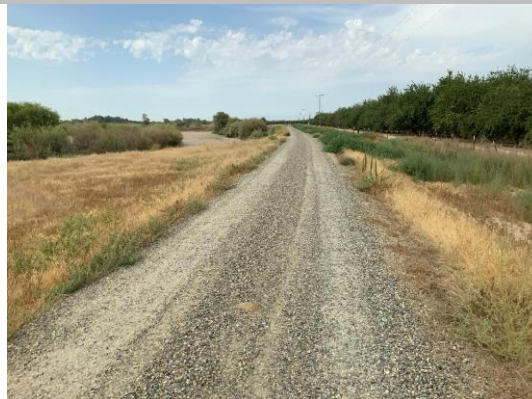
Photo 1 of 3 : UCIP\_FA\_2021\_68621\_102685.jpg

Comment Code					
Inspector Comment					
DS_ID:19561 FS_ID:68621 EP_NO: N/A Repair Type: Non-Urgent EVAL Issue: Pipe Not Found Crossing Status: Not Found UCIP Comments: 07/19/2021 The record has been upgraded from No Action Needed to Non-Urgent. Pipe not found by visual inspection. DWR DMP geophysical study did not confirm presence of pipe through levee. Record will remain in UCIP's inspection records until future Levee Improvement Project can confirm no crossing was found through the levee. No permit was found authorizing this encroachment. CVFPB will need to review crossing to determine owner. This portion of the levee has a levee prism less than 3 feet, appears to be high ground. The UCIP inspection was completed with GEI staff, P. Espinoza. (H. Dunn – GEI) FIELD_STRUCT_DESC: 16-inch steel gravity irrigation pipe through the levee, 2 feet below the crown. Well on the waterside (WS). [Additional Reference(s): USACE San Joaquin O&M Manual, Unit 601 Part 1 (SJR601.1), 1967, Revised 25 May 2011, (HLM 0.21), listed as a 16-inch steel pipe] FS Date: 7/19/2021

Levee crown.

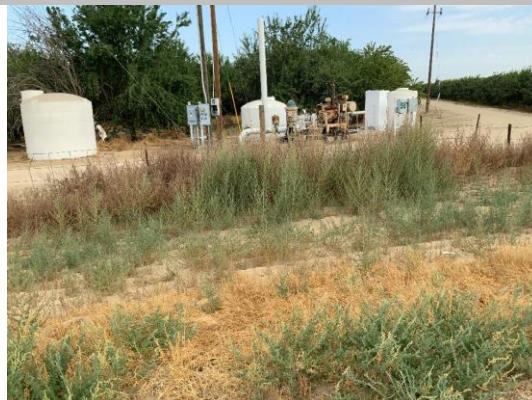
Photo 2 of 3 : UCIP\_FA\_2021\_68621\_102686.jpg

LS view: Toe from crown, no pipe visible.

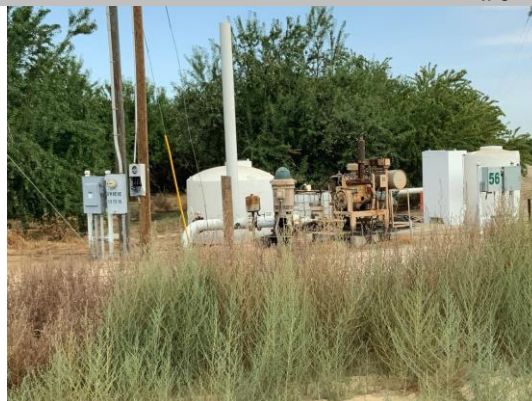
Photo 3 of 3 : UCIP\_FA\_2021\_68621\_102687.jpg

LS view: Pump and pipe system off the toe.

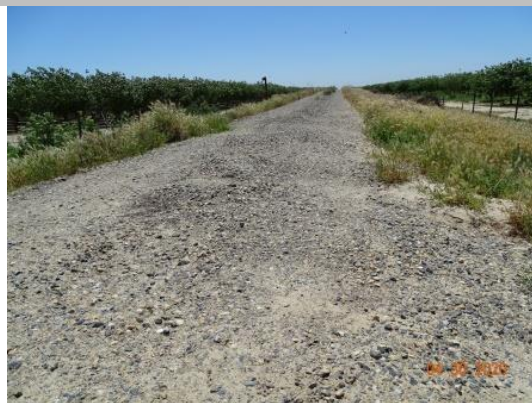
Photo 1 of 1 : FA\_2021\_NA0010\_139\_65\_20210830\_00011.jpg

LM Start	9.74	Rating **	M	Issue No.	65
LM End	9.74	Issue Type +	Ma	Location *	CR
Category	Earthen Levee			GPS Latitude/Longitude	
				Start	End
Item	Crown Surface / Depressions / Rutting			36.807603 °	36.807603 °
				-120.168825 °	-120.168825 °
DWR ID	DWR_NA0010_23_s_2019_65				
Comment Code					
C2 : Repair depressions or ruts in the crown or slope.					
Inspector Comment

Depressions forming in the levee crown. (Spring 2020)

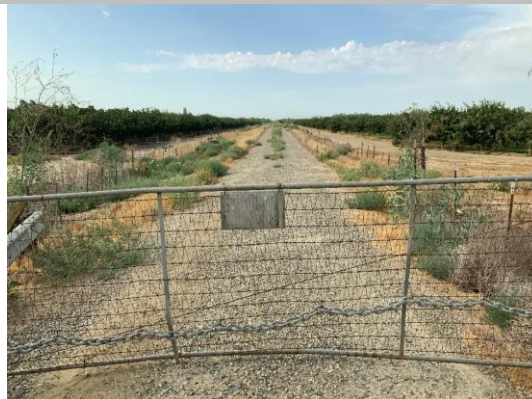
Photo 1 of 3 : UCIP\_FA\_2021\_68911\_102711.jpg

DS\_ID:19943  
FS\_ID:68911  
EP\_NO: N/A  
Repair Type: Non-Urgent  
EVAL Issue: Limited Inspection/No UCIP Evaluation  
Crossing Status: Found  
UCIP Comments: 07/19/2021 The record remains Non-Urgent. Limited access to both LS and WS due to steep slopes and vegetation. Both WS outlet and LS inlet have sediment buildup, recommend clearing out. No permit was found authorizing this encroachment. CVFPB will need to review crossing to determine owner. This portion of the levee has a levee prism less than 3 feet, appears to be high ground. The UCIP inspection was completed with GEI staff, P. Espinoza. (H. Dunn – GEI) 11/01/2018 Limited access to both LS and WS; assumed slide gates are still non-functional; Crossing has been downgraded from Urgent to Non-Urgent due to re-classification of damage slide gates. (O. Magana - DWR UCIP)07/20/2016 No change--same as previous inspection. (O. Magana - DWR UCIP)04/03/2014 Slide gate not functional. Slide gate channels heavily corroded (exfoliated) and likely impact functionality/structural integrity of gate. (W. Wylie - DWR UCIP) FIELD\_STRUCT\_DESC: [Gravelly Ford Canal Irrigation Structure] 1 of 2: 48-inch by 63-inch reinforced concrete box gravity irrigation culvert through the levee, 10 feet below the crown. Concrete U-shaped headwall on each end. Gear pedestal slide gate with wall bracket on the waterside (WS) headwall. 10-foot-long cobble revetted outlet channel. Guardrail on each shoulder. Slide gates on the WS. [Additional Reference(s): DWR Levee Log, 2002 (HLM 9.76), listed as a two 4.0-foot by 5.25-foot reinforced concrete box culvert (RCBC). USACE San Joaquin O&M Manual, Unit 601 Part 1 (SJR601.1), 1967, Revised 25 May 2011, (HLM 9.76), listed as a two 5.25-foot by 4-foot barrel RCBC] FS Date: 7/19/2021

Levee crown.

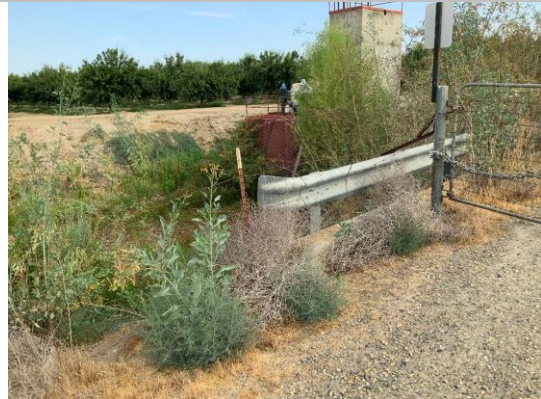
Photo 2 of 3 : UCIP\_FA\_2021\_68911\_102708.jpg

LS view: Toe from crown.

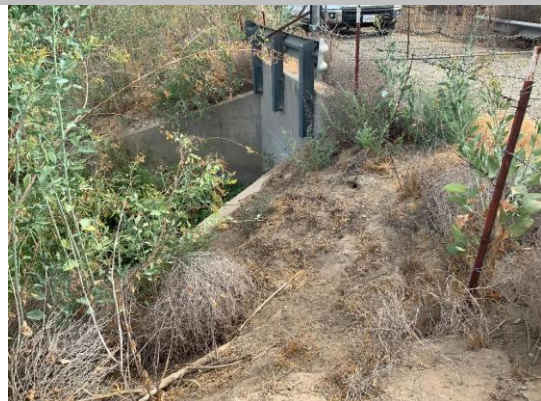
Photo 3 of 3 : UCIP\_FA\_2021\_68911\_102709.jpg

LS view: Slope and headwall from toe.

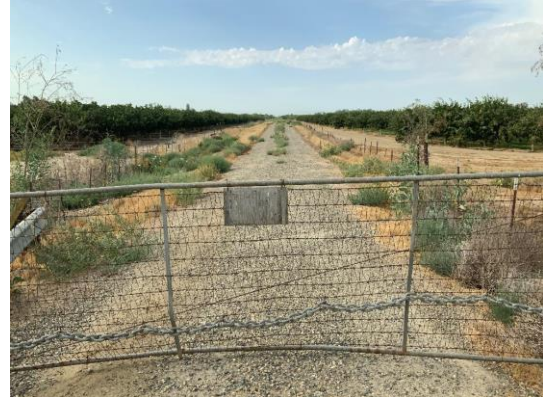
Photo 1 of 3 : UCIP\_FA\_2021\_68912\_102718.jpg

DS\_ID:19980  
FS\_ID:68912  
EP\_NO: N/A  
Repair Type: Non-Urgent  
EVAL Issue: Limited Inspection/No UCIP Evaluation  
Crossing Status: Found  
UCIP Comments: 07/19/2021 The record remains Non-Urgent. Limited access to both LS and WS due to steep slopes and vegetation. Both WS outlet and LS inlet have sediment buildup, recommend clearing out. No permit was found authorizing this encroachment. CVFPB will need to review crossing to determine owner. This portion of the levee has a levee prism less than 3 feet, appears to be high ground. The UCIP inspection was completed with GEI staff, P. Espinoza. (H. Dunn – GEI) 11/01/2018 Limited access to both LS and WS; assumed slide gates are still non-functional; Crossing has been downgraded from Urgent to Non-Urgent due to re-classification of damage slide gates. (O. Magana - DWR UCIP)07/20/2016 No change--same as previous inspection. (O. Magana - DWR UCIP)04/03/2014 Slide gate not functional. Slide gate channels heavily corroded (exfoliated) and likely impact functionality/structural integrity of gate. (W. Wylie - DWR UCIP) FIELD\_STRUCT\_DESC: [Gravelly Ford Canal Irrigation Structure] 2 of 2: 48-inch by 63-inch reinforced concrete box gravity irrigation culvert through the levee, 10 feet below the crown. Concrete U-shaped headwall on each end. Gear pedestal slide gate with wall bracket on the waterside (WS) headwall. 10-foot-long cobble revetted outlet channel. Guardrail on each shoulder. [Additional Reference(s): DWR Levee Log, 2002 (HLM 9.76), listed as a two 4.0-foot by 5.25-foot reinforced concrete box culvert (RCBC). USACE San Joaquin O&M Manual, Unit 601 Part 1 (SJR601.1), 1967, Revised 25 May 2011, (HLM 9.76), listed as a two 5.25-foot by 4-foot barrel RCBC].

Levee crown.

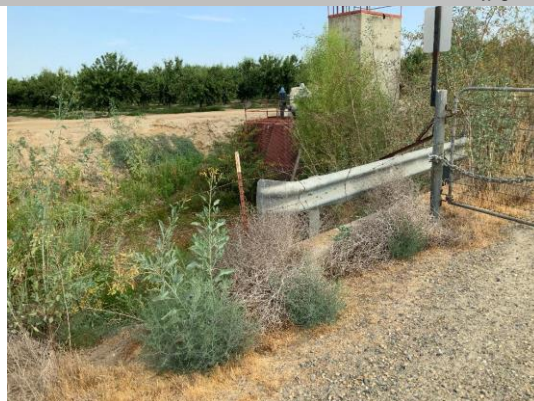
Photo 2 of 3 : UCIP\_FA\_2021\_68912\_102715.jpg

LS view: Toe from crown.

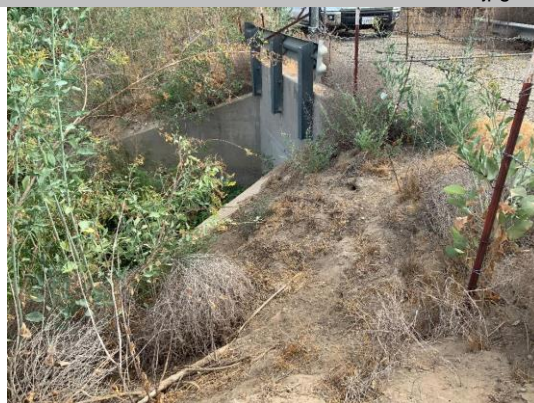
Photo 3 of 3 : UCIP\_FA\_2021\_68912\_102716.jpg

LS view: Slope and headwall from toe.

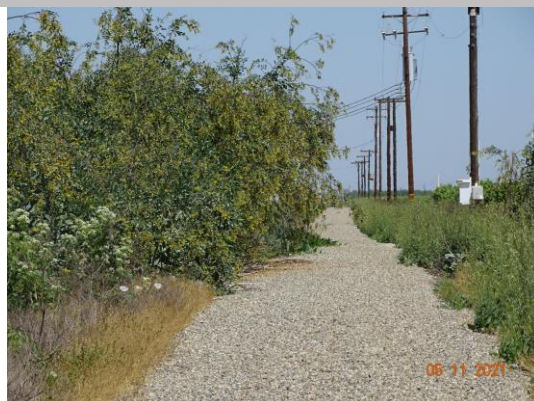
Photo 1 of 1 : FA\_2021\_NA0010\_139\_58\_20210830\_00010.jpg

LM Start	9.76	Rating **	M	Issue No.	58
LM End	9.81	Issue Type +	Ma	Location *	LS
Category	Earthen Levee			GPS Latitude/Longitude	
				Start	End
Item	Trim / Thin Trees			36.807810 °	36.808553 °
				-120.168829 °	-120.168827 °
DWR ID	DWR_NA0010_23_f _ 2018_58				
Comment Code					
T2 : Thin trees to allow visibility of the ground and room to flood fight.					
Inspector Comment					
Woody vegetation is partially blocking crown and landside slope.

Woody vegetation on landside toe obstructing landside of crown. (Spring 2021)

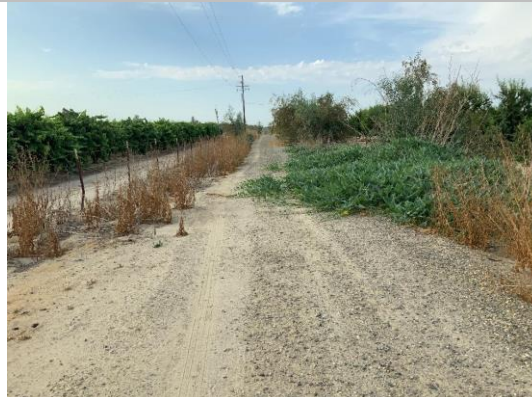
Photo 1 of 3 : UCIP\_FA\_2021\_68618\_102724.jpg

DS\_ID:19684  
FS\_ID:68618  
EP\_NO: 15399  
Repair Type: Non-Urgent  
EVAL Issue: Safety Issue  
Crossing Status: Indicator Found  
UCIP Comments: 07/19/2021 The record has been upgraded from No Action Needed to Non-Urgent. As a safety measure, need to coordinate with owner to determine status of line and to obtain maintenance and inspection records to confirm integrity of line through the levee. This portion of the levee has a levee prism less than 3 feet, appears to be high ground. The UCIP inspection was completed with GEI staff, P. Espinoza. (H. Dunn – GEI11/30/2015 Markers are now present at this location for gas line. Photos provided by DWR Inspector in November 2015. (O. Magana - DWR UCIP)04/03/2014 Need to install gasoline markers at crossing. (W. Wylie - DWR UCIP)  
FIELD\_STRUCT\_DESC: 6-inch coated steel natural gas pipeline through the levee, at an unknown depth. Location identified on Pacific Gas and Electric Company (PG&E) website. No signs on levee.

Levee crown.

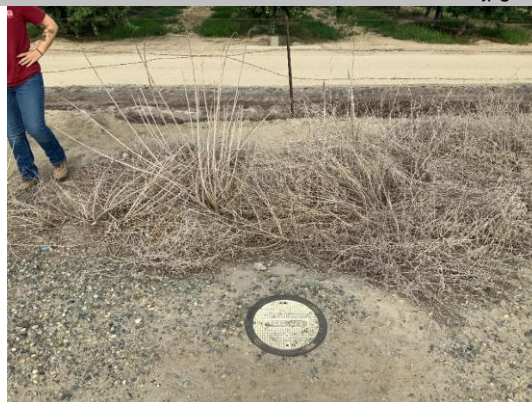
Photo 2 of 3 : UCIP\_FA\_2021\_68618\_102727.jpg

LS view: Toe from crown, manhole visible.

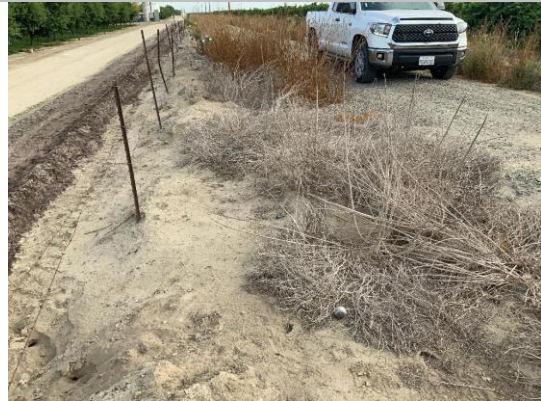
Photo 3 of 3 : UCIP\_FA\_2021\_68618\_102728.jpg

LS view: Slope from toe.

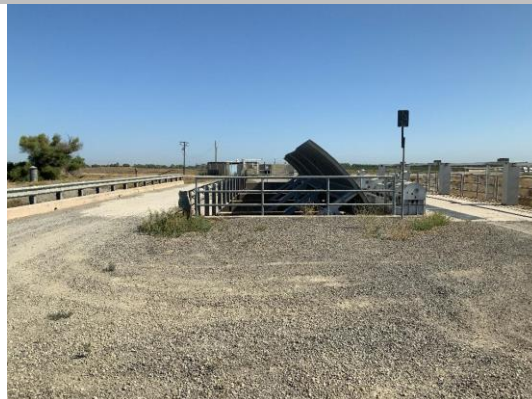
Photo 1 of 3 : UCIP\_FA\_2021\_68628\_102745.jpg

DS\_ID:19982  
FS\_ID:68628  
EP\_NO: N/A  
Repair Type: Non-Urgent  
EVAL Issue: Unauthorized Encroachment, installed decades prior  
Crossing Status: Found  
UCIP Comments: 07/20/2021 The record has been upgraded from No Action Needed to Non-Urgent. No permit was found authorizing this encroachment. CVFPB will need to review crossing to determine owner. The UCIP inspection was completed with GEI staff, P. Espinoza. (H. Dunn – GEI) 10/27/2017 This structure is inspected annually under the Structure and Channel Summer Inspection (part of the Levee Inspection Program) conducted by the DWR Flood Project Integrity and Inspection Branch (FPIIB). (O. Magana - DWR UCIP)  
FIELD\_STRUCT\_DESC: [San Joaquin River Control Structure] Four 216-inch by 240-inch reinforced concrete box gravity drainage culvert openings with electrically operated gates. Trash racks in front of the gates. Wing walls on the downstream side of the structure. Bridge across the structure to the right bank levee of the Chowchilla Canal Bypass. [Additional Reference(s): DWR Levee Log, 2002 (HLM 0.00), listed as four 18-foot by 20-foot openings with electrically operated gates]

Levee crown.

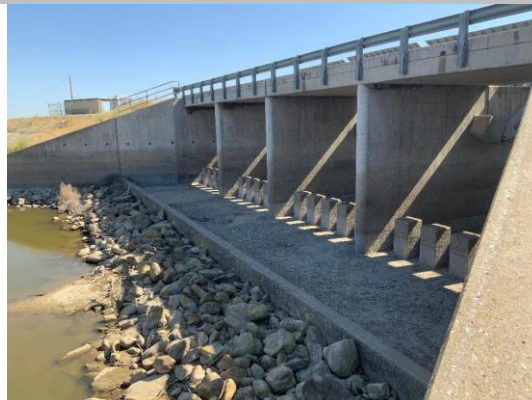
Photo 2 of 3 : UCIP\_FA\_2021\_68628\_102744.jpg

LS view: Inlets and headwall visible from toe.

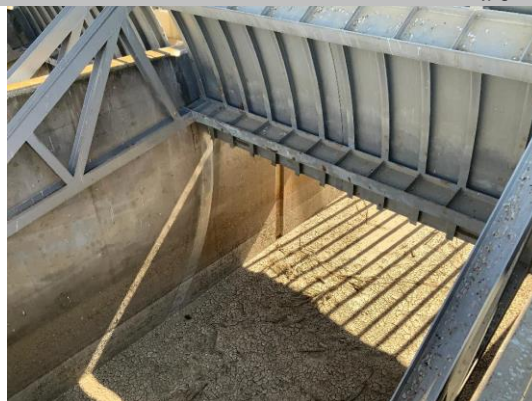
Photo 3 of 3 : UCIP\_FA\_2021\_68628\_102747.jpg

LS view: Closeup of inlet at toe.

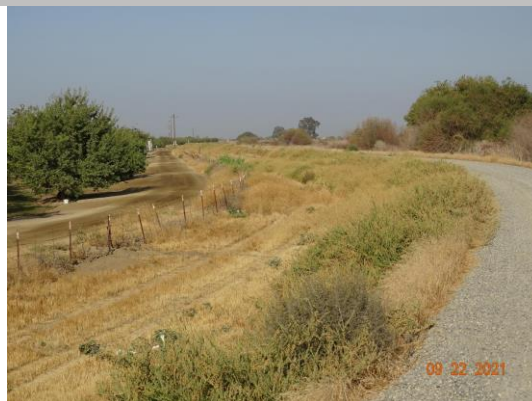
Photo 1 of 1 : FA\_2021\_NA0010\_140\_37\_20211008\_00051.jpg

LM Start	0.05	Rating **	M	Issue No.	37
LM End	3.51	Issue Type +	Ma	Location *	LS
Category	Earthen Levee			GPS Latitude/Longitude	
				Start	End
Item	Vegetation			36.772488 °	36.769055 °
				-120.285178 °	-120.237589 °
DWR ID	DWR_NA0010_24_f_2021_37				
Comment Code					
V1 : Control annual grass and weeds on the levee slopes and easements.					
Inspector Comment

Looking downstream at vegetation along the landside slope. (Fall 2021)

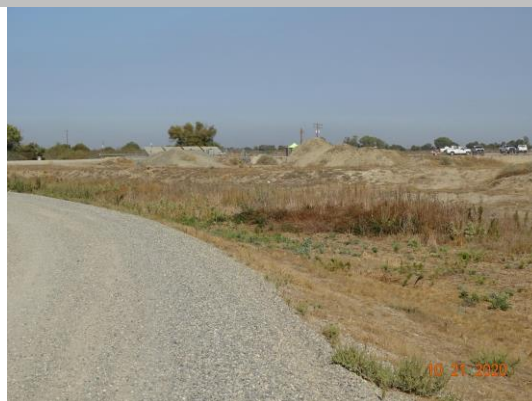
Photo 1 of 1 : FA\_2021\_NA0010\_140\_47\_20210830\_00012.jpg

LM Start	0.06	Rating **	M	Issue No.	47
LM End	0.06	Issue Type +	En	Location *	WS
Category	Earthen Levee			GPS Latitude/Longitude	
				Start	End
Item	Encroachments			36.772328 °	36.772328 °
				-120.285117 °	-120.285117 °
DWR ID	DWR_NA0010_24_s_2014_47				
Comment Code					
MA : Material					
Inspector Comment					
The District constructed a berm on waterside slope. The berm is being used for staging of earthen material.

Berm and material constructed off the waterside slope. (Fall 2020)

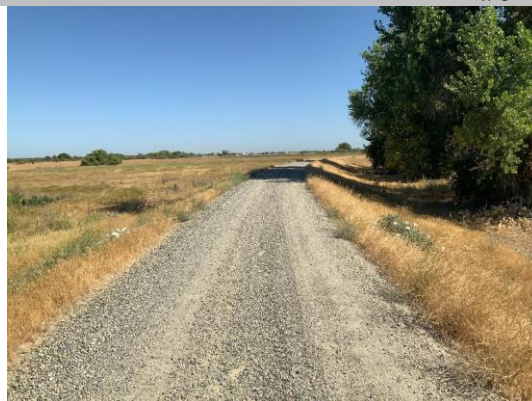
Photo 1 of 3 : UCIP\_FA\_2021\_68915\_102757.jpg

DS\_ID:19685  
 FS\_ID:68915  
 EP\_NO: 15399  
 Repair Type: Non-Urgent  
 EVAL Issue: Safety Issue  
 Crossing Status: Not Found  
 UCIP Comments: 07/20/2021 The record is Non-Urgent. Pipe not found by visual inspection. As a safety measure, need to coordinate with owner to determine status of line and to obtain maintenance and inspection records to confirm integrity of line through the levee. The UCIP inspection was completed with GEI staff, P. Espinoza. (H. Dunn – GEI)  
 FIELD\_STRUCT\_DESC: 6-inch coated steel natural gas pipeline through the levee, 3 feet below the crown. Control valve 10 feet off the landside (LS) toe. Pipeline extends under the channel and through the levee on the opposite bank. (Plans to install a 6-inch welded steel natural gas pipeline under the channel and within both levees of the San Joaquin River and the Chowchilla Bypass authorized under Permit No. 15399, 1990 - California Gas Gathering, Inc.).

Levee crown.

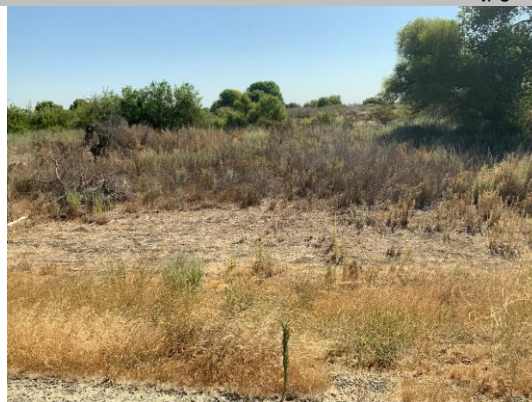
Photo 2 of 3 : UCIP\_FA\_2021\_68915\_102759.jpg

LS view: Toe from crown, no pipe visible.

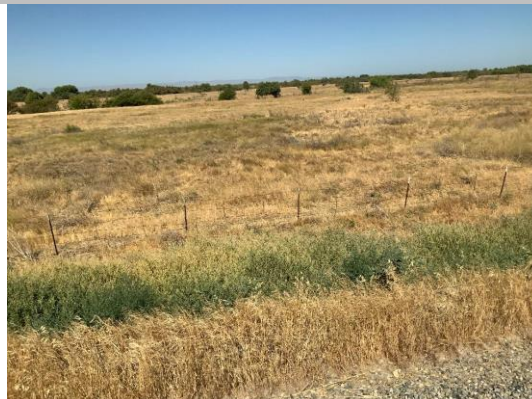
Photo 3 of 3 : UCIP\_FA\_2021\_68915\_102758.jpg

WS view: Toe from crown, no pipe visible.

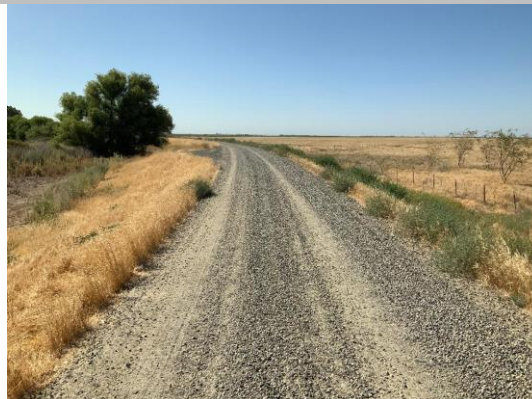
Photo 1 of 3 : UCIP\_FA\_2021\_68631\_102762.jpg

DS\_ID:19955  
 FS\_ID:68631  
 EP\_NO: N/A  
 Repair Type: Non-Urgent  
 EVAL Issue: Limited Inspection/No UCIP Evaluation  
 Crossing Status: Found  
 UCIP Comments: 07/20/2021 The record remains Non-Urgent. Cannot access LS inlet due to barbed wire, but appears to have sediment buildup. WS flapgate inaccessible due to steep hill and dense vegetation, recommend clearing vegetation and sediment out on both WS and LS inlet/outlet. No permit was found authorizing this encroachment. CVFPB will need to review crossing to determine owner. The UCIP inspection was completed with GEI staff, P. Espinoza. (H. Dunn – GEI)04/08/2014 No access available to confirm condition of landward side headwall. Recommend clearing debris along fence. Surface erosion near concrete headwall on landward side was present. (O. Magana - DWR UCIP)  
 FIELD\_STRUCT\_DESC: 30-inch by 30-inch square reinforced concrete box gravity drainage culvert through the levee, 13.5 feet below the crown. Flap gate on the waterside (WS) end. Concrete headwall on each end. [Additional Reference(s): DWR Levee Log, 2002 (HLM 0.49), listed as a 30-inch square concrete culvert].

Levee crown.

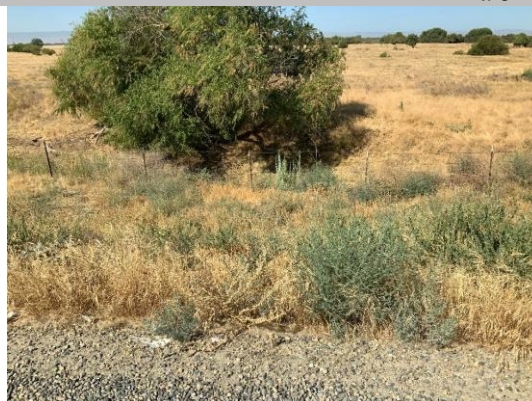
Photo 2 of 3 : UCIP\_FA\_2021\_68631\_102763.jpg

LS view: Toe from crown.

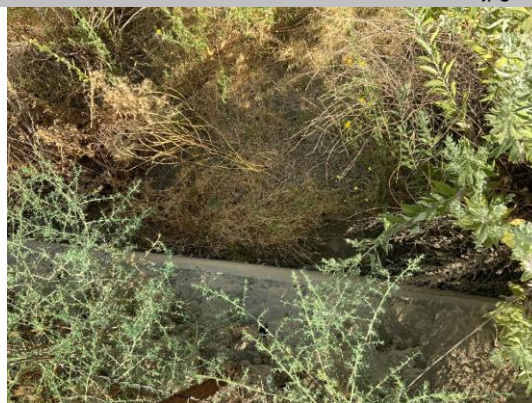
Photo 3 of 3 : UCIP\_FA\_2021\_68631\_102764.jpg

LS view: Top of headwall at toe.

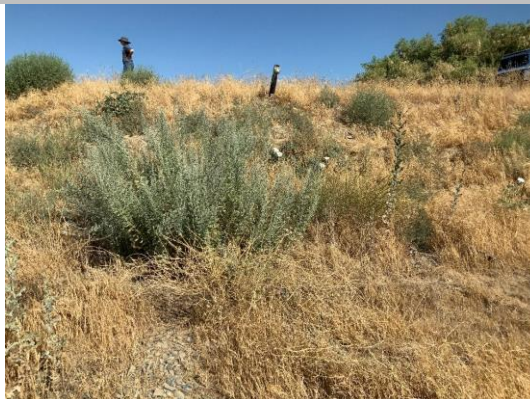
Photo 3 of 3 : UCIP\_FA\_2021\_68916\_102772.jpg

LS view: Slope from toe.

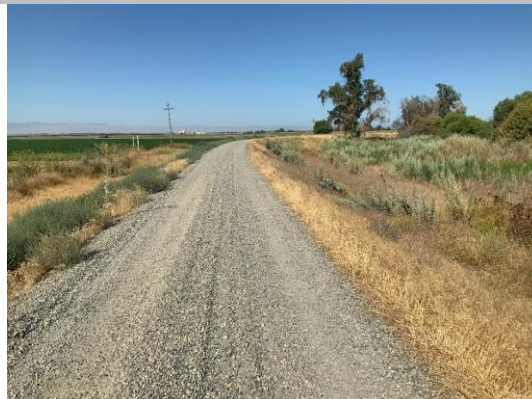
Photo 1 of 3 : UCIP\_FA\_2021\_68917\_102777.jpg

DS\_ID:19962  
FS\_ID:68917  
EP\_NO: 13085  
Repair Type: Non-Urgent  
EVAL Issue: Abandoned encroachment  
Crossing Status: Indicator Found  
UCIP Comments: 07/20/2021 The record remains Non-Urgent. No pipe inlet/outlet found on WS or LS. Only small riser indicator seen on the LS shoulder. Appears abandoned due to no actual pipe, cutoff wall, riprap, or vent pipe visible. Confirm with owner on the alignment and status of this pipe. The UCIP inspection was completed with GEI staff, P. Espinoza. (H. Dunn – GEI) 04/08/2014 Need to contact owner to determine status. (O. Magana - DWR UCIP)  
FIELD\_STRUCT\_DESC: 20-inch coated steel gravity drainage pipe through the levee, 2 feet below the crown. Pipe encased in concrete through the levee crown. Steel cutoff wall around the pipe at each shoulder. Siphon breaker installed on the apex of the pipe on the landside (LS) shoulder. Vent pipe on LS shoulder. Rock riprap on the waterside (WS) slope. (Plans to construct a new discharge structure and to rehabilitate one existing diversion structure to return intercepted seepage to the San Joaquin River authorized under Permit No. 13085, 1981 - Diener, Dry River Farms). [Additional Reference(s): DWR Levee Log, 2002 (HLM 1.75), listed as a 20-inch steel pipe].

Levee crown.

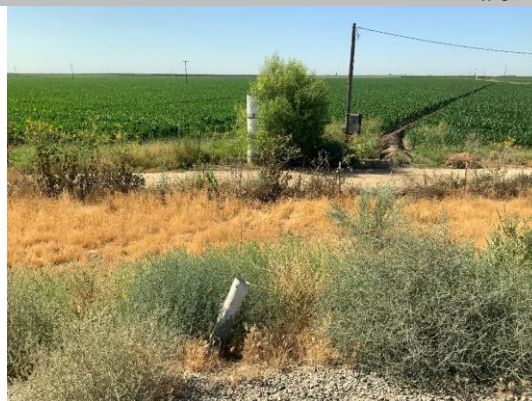
Photo 2 of 3 : UCIP\_FA\_2021\_68917\_102778.jpg

LS view: Small riser visible on the slope from the crown.

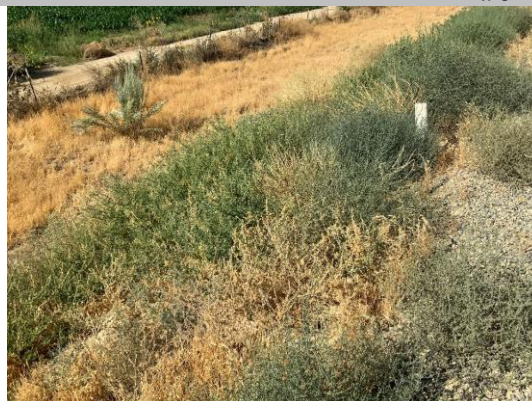
Photo 3 of 3 : UCIP\_FA\_2021\_68917\_102779.jpg

LS view: Slope from crown, no pipe visible.

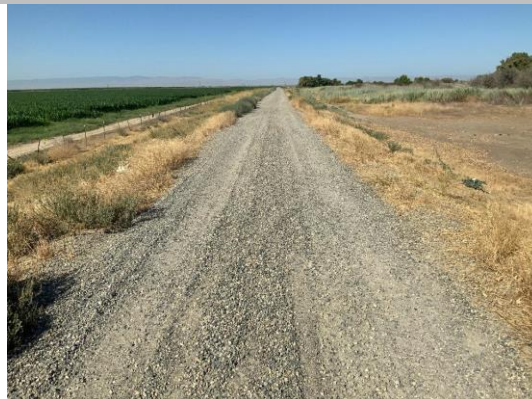
Photo 1 of 3 : UCIP\_FA\_2021\_68918\_102784.jpg

DS\_ID:19963  
FS\_ID:68918  
EP\_NO: 13735  
Repair Type: Non-Urgent  
EVAL Issue: Abandoned encroachment  
Crossing Status: Indicator Found  
UCIP Comments: 07/20/2021 The record remains Non-Urgent. No pipe inlet or outlet found on WS or LS. Only siphon breaker on LS slope and well pump seen off the LS toe. Appears abandoned due to no actual pipe, cutoff wall, or vent pipe seen. Confirm with the owner on alignment and status of this pipe. The UCIP inspection was completed with GEI staff, P. Espinoza. (H. Dunn – GEI) 04/08/2014 Unable to confirm status of crossing. (O. Magana - DWR UCIP)  
FIELD\_STRUCT\_DESC: 24-inch coated steel drainage discharge pipe through the levee, 2 feet below the crown. Crown roadway has been padded 1 foot. Steel cutoff wall around the pipe at the centerline of the levee. Pump on the landside (LS). Siphon breaker on the apex of the pipe on the LS shoulder. Galvanized siphon vent pipe on the LS shoulder. (Plans to install two 24-inch steel discharge pipelines through the levee to dispose of seepage water collected in farm sumps Nos. 8 and 12 authorized under Permit No. 13735, 1983 - Rio Seco Farm).

Levee crown.
