## Flood Control Project Maintenance Levee Inspections

### Fall 2021 Levee Maintenance Deficiency Summary Report

#### San Joaquin River Basin

NA0010 Lower San Joaquin Levee District	Overall LMA Rating	Total LMA Miles							
	U	191.27							
Rated Item	Maintenance Deficiency				Enforcement		Design & System Obsolescence		
	M Miles	U Miles	M + 4U Miles	Threshold %	M Miles	U Miles	M Miles	U Miles	
<i>Earthen Levee</i>									
Vegetation	47.00	9.57	85.28	44.59%					
Trim / Thin Trees	0.10		0.10	0.05%					
Encroachments	0.23	0.02	0.31	0.16%	9.29	0.59			
Animal Control	7.67	2.19	16.43	8.59%					
Slope Stability	0.05	0.01	0.09	0.05%					
Erosion / Bank Caving	0.13	0.81	3.37	1.76%					
Crown Surface / Depressions / Rutting	0.01		0.01	0.01%					
Repair Gates	0.02	0.02	0.10	0.05%					
<i>Rivers, Channels &amp; Designated Floodways</i>									
Encroachments					0.01	0.01			
<i>Supplemental</i>									
DWR Erosion Survey	0.12	0.17	0.80	0.42%					
DWR UCIP Field Study					1.29	0.05			
DWR UCIP LMA Responsibility									
<i>LMA Totals:</i>	55.33	12.79	106.49	55.67%	10.59	0.65	0.00	0.00

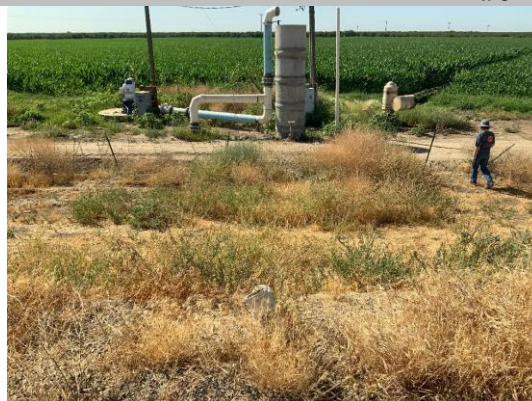
Photo 2 of 3 : UCIP\_FA\_2021\_68918\_102785.jpg

LS view: Siphon breaker visible on slope from crown.

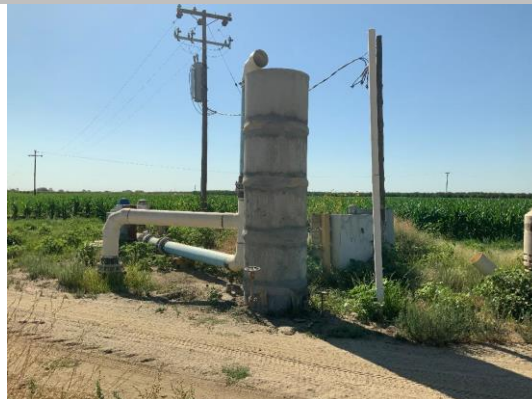
Photo 3 of 3 : UCIP\_FA\_2021\_68918\_102786.jpg

LS view: Well and pump station off the toe.

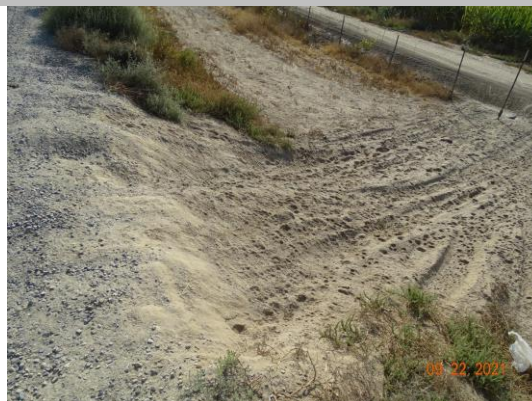
Photo 1 of 1 : FA\_2021\_NA0010\_140\_39\_20211008\_00052.jpg

LM Start	2.77	Rating **	M	Issue No.	39
LM End	2.77	Issue Type +	Ma	Location *	LS
Category	Earthen Levee			GPS Latitude/Longitude	
				Start	End
Item	Slope Stability			36.772289 °	36.772289 °
				-120.249693 °	-120.249693 °
DWR ID	DWR_NA0010_24_f_2021_39				
Comment Code					
S2 : Repair the levee slope damaged by foot traffic and prevent access where possible.					
Inspector Comment

Damage to the landside slope from vehicle traffic. (Fall 2021)

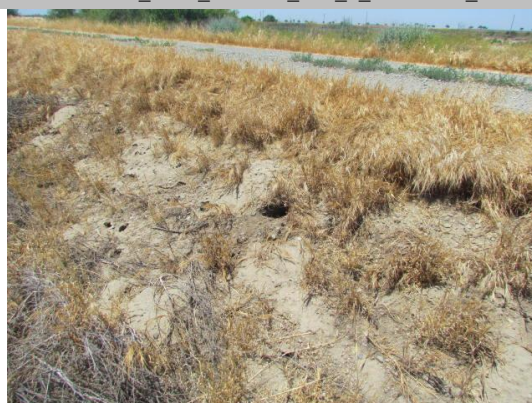
Photo 1 of 1 : FA\_2021\_NA0010\_140\_7\_20210830\_00002.jpg

LM Start	3.46	Rating **	M	Issue No.	7
LM End	3.46	Issue Type +	Ma	Location *	LS
Category	Earthen Levee			GPS Latitude/Longitude	
				Start	End
Item	Animal Control			36.769345 °	36.769345 °
				-120.238370 °	-120.238370 °
DWR ID	DWR_NA0010_24_s_2012_7				
Comment Code					
A3 : No rodents visible, but rodent burrows visible; need to backfill and compact or grout burrows.					
Inspector Comment					
There are several rodent holes on the landside slope.

Looking east at one of several rodent holes on landward slope.

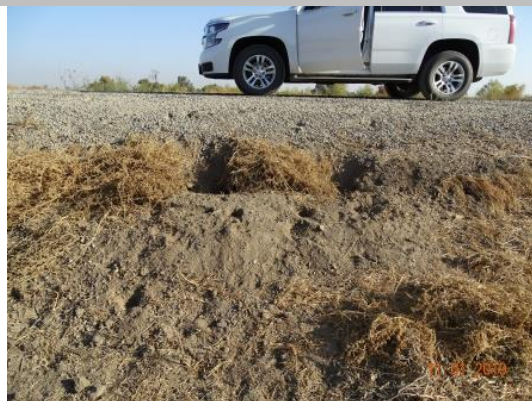
Photo 1 of 1 : FA\_2021\_NA0010\_140\_28\_20210830\_00011.jpg

LM Start	3.53	Rating **	M	Issue No.	28
LM End	3.59	Issue Type +	Ma	Location *	LS
Category	Earthen Levee			GPS Latitude/Longitude	
				Start	End
Item	Animal Control			36.768886 °	36.768531 °
				-120.237154 °	-120.236226 °
DWR ID	DWR_NA0010_24_f_2019_28				
Comment Code					
A3 : No rodents visible, but rodent burrows visible; need to backfill and compact or grout burrows.					
Inspector Comment

View of rodent burrows in the landside slope. (Fall 2019)

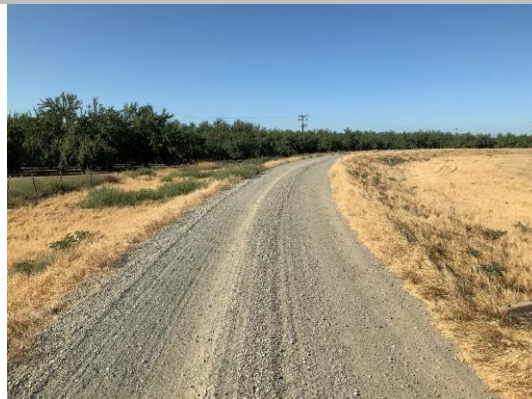
Photo 1 of 3 : UCIP\_FA\_2021\_69550\_102802.jpg

DS\_ID:19964  
FS\_ID:69550  
EP\_NO: N/A  
Repair Type: Non-Urgent  
EVAL Issue: Unauthorized Encroachment, installed decades prior  
Crossing Status: Found  
UCIP Comments: 07/20/2021 The record remains Non-Urgent. No inlet or outlet found on WS or LS. Slidegate found on WS slope and concrete riser visible off the LS toe. Appears abandoned, no pump attached. Confirm with owner on the alignment and status of this pipe. No permit was found authorizing this encroachment. CVFPB will need to review crossing to determine owner. The UCIP inspection was completed with GEI staff, P. Espinoza. (H. Dunn – GEI) 04/08/2014 Unable to confirm crossing alignment and appurtenances associated with this crossing. Multiple stand pipes visible on landward side. Need to contact owner to determine status of crossing and alignment. (O. Magana - DWR UCIP)  
FIELD\_STRUCT\_DESC: 30-inch by 30-inch square reinforced concrete box drainage discharge culvert through the levee, 12.5 feet below the crown. Pump on the landside (LS). Concrete riser with slide gate on the waterside (WS) slope. Screw gate on the LS shoulder. (Plans to construct a new discharge structure and to rehabilitate one existing diversion structure to return intercepted seepage to the San Joaquin River authorized under Permit No. 13085, 1981 - Diener, Dry River Farms). [Additional Reference(s): DWR Levee Log, 2002 (HLM 4.05), listed as a 30-inch square reinforced concrete box culvert (RCBC)].

Levee crown.

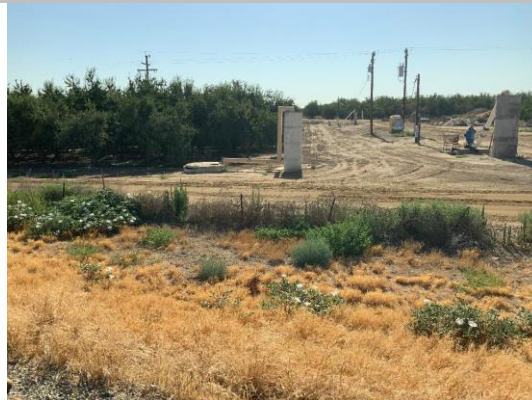
Photo 2 of 3 : UCIP\_FA\_2021\_69550\_102806.jpg

LS view: Toe from crown.

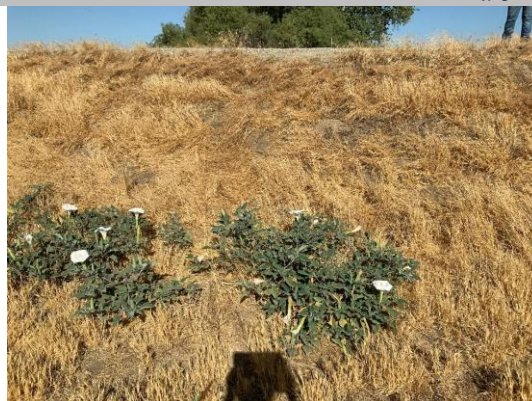
Photo 3 of 3 : UCIP\_FA\_2021\_69550\_102800.jpg

LS view: Slope from toe, no pipe visible.

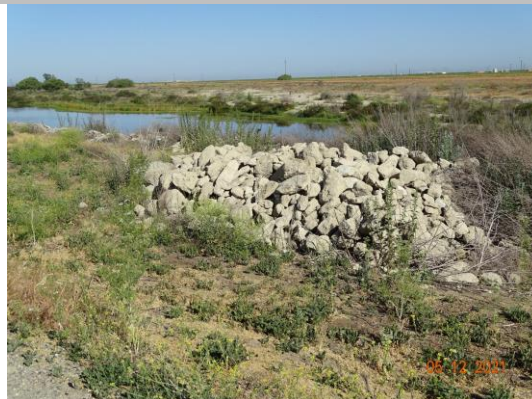
Photo 1 of 1 : FA\_2021\_NA0010\_140\_266\_20210830\_00014.jpg

LM Start	5.30	Rating **	M	Issue No.	266
LM End	5.30	Issue Type +	En	Location *	WS
Category	Earthen Levee			GPS Latitude/Longitude	
				Start	End
Item	Encroachments			36.781960 °	36.781960 °
				-120.224496 °	-120.224496 °
DWR ID	DWR_NA0010_24_s_2015_266				
Comment Code					
MA : Material					
Inspector Comment					
Rocks are stockpiled near the waterside toe.

Stockpile of rock kept in the river channel. (Spring 2021)

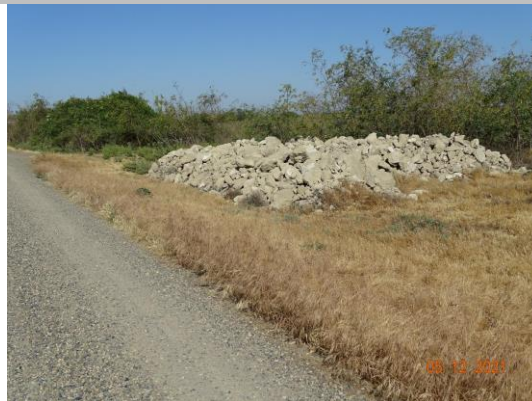
Photo 1 of 1 : FA\_2021\_NA0010\_140\_25\_20210830\_00010.jpg

LM Start	5.40	Rating **	M	Issue No.	25
LM End	5.40	Issue Type +	En	Location *	WS
Category	Earthen Levee			GPS Latitude/Longitude	
				Start	End
Item	Encroachments			36.782397 °	36.782397 °
				-120.222815 °	-120.222815 °
DWR ID	DWR_NA0010_24_s_2021_25				
Comment Code					
MA : Material					
Inspector Comment					
Rocks are stockpiled near the waterside toe.

Stockpile of rock kept at the waterside toe and river channel. (Spring 2021)

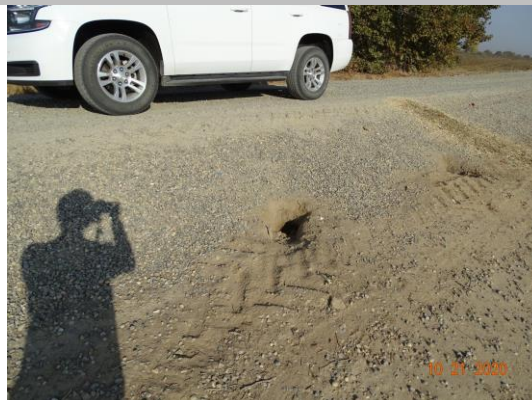
Photo 1 of 1 : FA\_2021\_NA0010\_140\_20\_20210830\_00008.jpg

LM Start	5.66	Rating **	M	Issue No.	20
LM End	5.66	Issue Type +	Ma	Location *	LS
Category	Earthen Levee			GPS Latitude/Longitude	
				Start	End
Item	Animal Control			36.784215 °	36.784215 °
				-120.218882 °	-120.218882 °
DWR ID	DWR_NA0010_24_f_2020_20				
Comment Code					
A3 : No rodents visible, but rodent burrows visible; need to backfill and compact or grout burrows.					
Inspector Comment

Rodent holes at the landside toe. (Fall 2020)

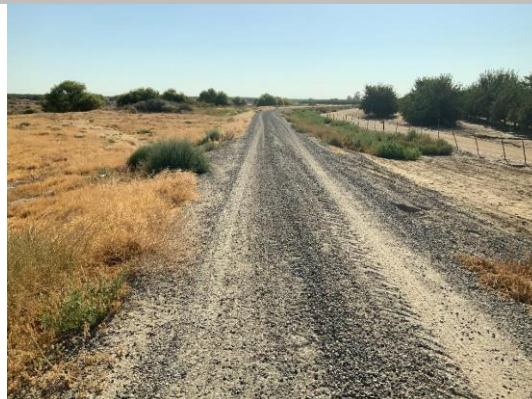
Photo 1 of 3 : UCIP\_FA\_2021\_68920\_102809.jpg

DS\_ID:19956  
 FS\_ID:68920  
 EP\_NO: N/A  
 Repair Type: Non-Urgent  
 EVAL Issue: Limited Inspection/No UCIP Evaluation  
 Crossing Status: Found  
 UCIP Comments: 07/20/2021 The record has been upgraded from No Action Needed to Non-Urgent. Limited inspection due to some vegetation covering LS pipe inlet, recommend removal. No permit was found authorizing this encroachment. CVFPB will need to review crossing to determine owner. Levee prism appears less than 3 feet in height. The UCIP inspection was completed with GEI staff, P. Espinoza. (H. Dunn – GEI)  
 FIELD\_STRUCT\_DESC: 24-inch corrugated metal gravity drainage pipe through the levee, 5 feet below the crown. Flap gate on the waterside (WS) end. Concrete headwall on the landside (LS) end. Concrete U-shaped headwall on the WS end. [Additional Reference(s): DWR Levee Log, 2002 (HLM 6.09), listed as a 24-inch corrugated metal pipe (CMP)].

Levee crown.

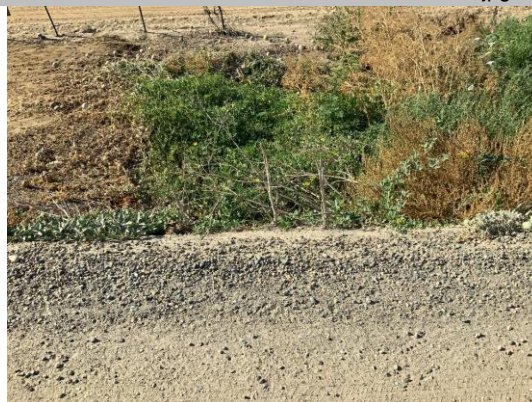
Photo 2 of 3 : UCIP\_FA\_2021\_68920\_102813.jpg

LS view: Toe from crown.

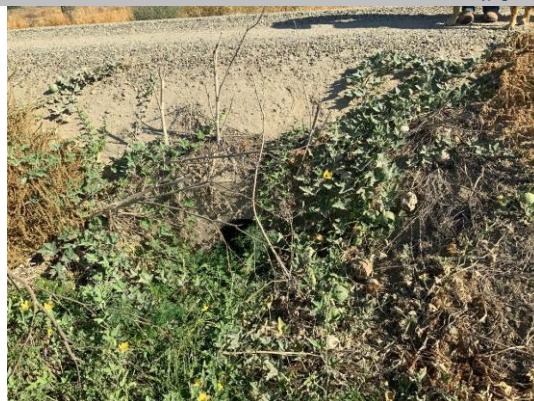
Photo 3 of 3 : UCIP\_FA\_2021\_68920\_102807.jpg

LS view: Slope from toe.

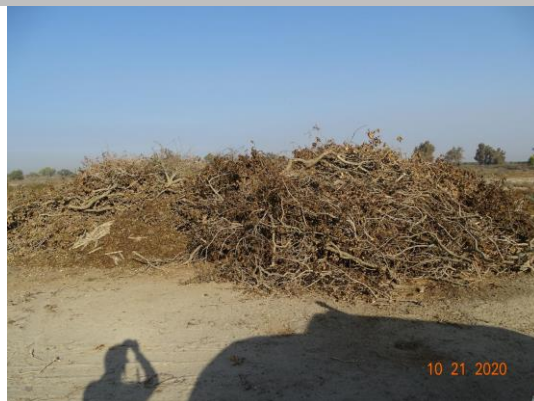
Photo 1 of 1 : FA\_2021\_NA0010\_140\_18\_20210830\_00006.jpg

LM Start	6.34	Rating **	U	Issue No.	18
LM End	6.34	Issue Type +	En	Location *	WS
Category	Earthen Levee			GPS Latitude/Longitude	
				Start	End
Item	Encroachments			36.788192 °	36.788192 °
				-120.209528 °	-120.209528 °
DWR ID	DWR_NA0010_24_f_2020_18				
Comment Code					
PR : Prunings					
Inspector Comment					
Prunings piled on the waterside berm.

Pruning pile left on the waterside toe. (Fall 2020)

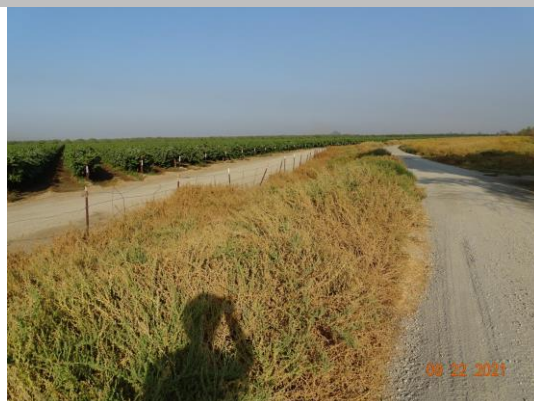
Photo 1 of 1 : FA\_2021\_NA0010\_140\_30\_20211008\_00053.jpg

LM Start	6.60	Rating **	U	Issue No.	30
LM End	7.33	Issue Type +	Ma	Location *	LS
Category	Earthen Levee			GPS Latitude/Longitude	
				Start	End
Item	Vegetation			36.788380 °	36.779380 °
				-120.205388 °	-120.199062 °
DWR ID	DWR_NA0010_24_f_2021_30				
Comment Code					
V1 : Control annual grass and weeds on the levee slopes and easements.					
Inspector Comment

View of vegetation on the landside slope. (Fall 2021)

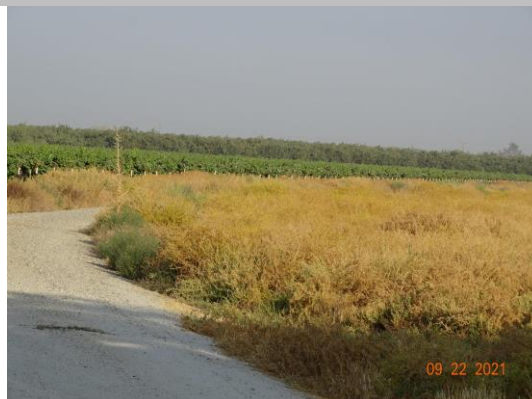
Photo 1 of 1 : FA\_2021\_NA0010\_140\_32\_20211008\_00054.jpg

LM Start	6.60	Rating **	U	Issue No.	32
LM End	7.30	Issue Type +	Ma	Location *	WS
Category	Earthen Levee			GPS Latitude/Longitude	
				Start	End
Item	Vegetation			36.788380 °	36.779650 °
				-120.205385 °	-120.199465 °
DWR ID	DWR_NA0010_24_f _ 2021_32				
Comment Code					
V1 : Control annual grass and weeds on the levee slopes and easements.					
Inspector Comment

Looking downstream along the waterside slope. (Fall 2021)

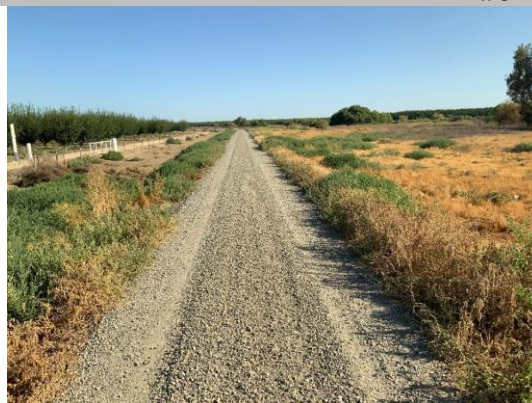
Photo 1 of 3 : UCIP\_FA\_2021\_68922\_102819.jpg

Comment Code						
Inspector Comment						
DS_ID:19957 FS_ID:68922 EP_NO: N/A Repair Type: Non-Urgent EVAL Issue: Limited Inspection/No UCIP Evaluation Crossing Status: Found UCIP Comments: 07/20/2021 The record remains Non-Urgent. Limited inspection due to some vegetation covering LS pipe inlet, recommend removal. No permit was found authorizing this encroachment. CVFPB will need to review crossing to determine owner. The levee prism appears to be less than 3 feet. The UCIP inspection was completed with GEI staff, P. Espinoza. (H. Dunn – GEI) 7/20/2016 same as previous inspection. Crossing has been downgraded from Urgent to Non-Urgent PVC does not prevent WS flap gate from closing. (O. Magana - DWR UCIP)4/08/2014 Unauthorized PVC pipe through existing crossing. PVC distorted inside--Need to contact owner to correct issue. If crossing was allowed need to contact owner for permit number issue for crossing variance. (O. Magana - DWR UCIP) FIELD_STRUCT_DESC: 24-inch corrugated metal gravity drainage pipe through the levee, 3.6 feet below the crown. Flap gate on the waterside (WS) end. Concrete headwall on the landside (LS) end. Concrete U-shaped headwall on the WS end. [Additional Reference(s): DWR Levee Log, 2002 (HLM 6.72), listed as a 24-inch corrugated metal pipe (CMP)]. FS Date: 7/20/2021

Levee crown.

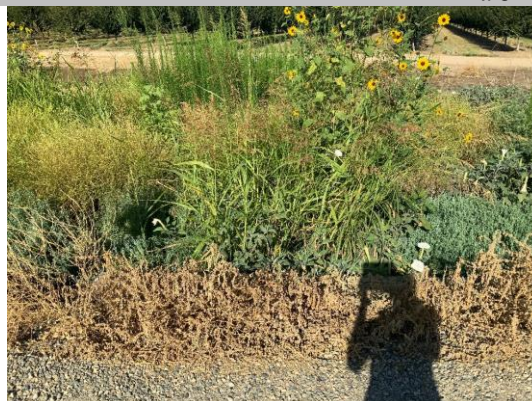
Photo 2 of 3 : UCIP\_FA\_2021\_68922\_102820.jpg

LS view: Toe from crown.

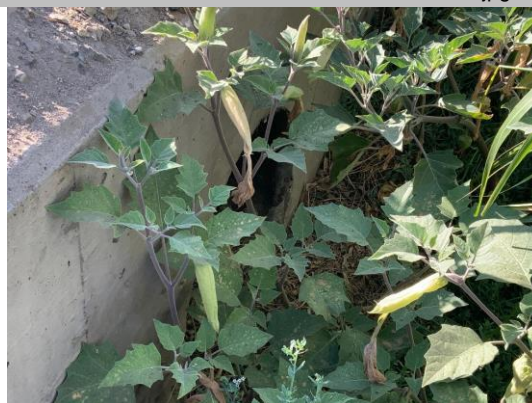
Photo 3 of 3 : UCIP\_FA\_2021\_68922\_102814.jpg

LS view: Closeup of pipe inlet at toe with vegetation overgrowth.

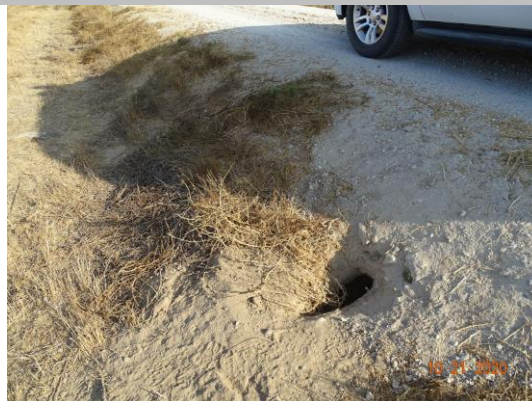
Photo 1 of 1 : FA\_2021\_NA0010\_140\_14\_20210830\_00005.jpg

LM Start	6.86	Rating **	M	Issue No.	14
LM End	6.86	Issue Type +	Ma	Location *	LS
Category	Earthen Levee			GPS Latitude/Longitude	
				Start	End
Item	Animal Control			36.784716 °	36.784716 °
				-120.204043 °	-120.204043 °
DWR ID	DWR_NA0010_24_f_2020_14				
Comment Code					
A3 : No rodents visible, but rodent burrows visible; need to backfill and compact or grout burrows.					
Inspector Comment

Rodent burrow on the landside slope. (Fall 2020)

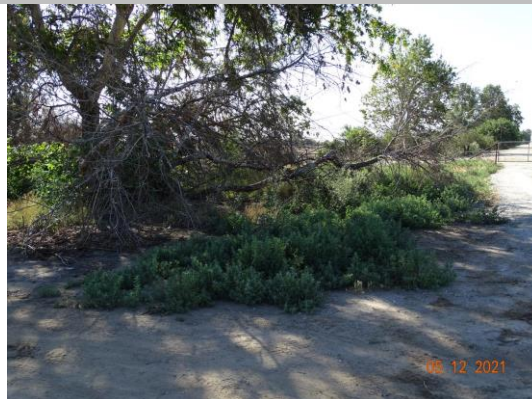
Photo 1 of 1 : FA\_2021\_NA0010\_140\_21\_20210830\_00009.jpg

LM Start	7.33	Rating **	U	Issue No.	21
LM End	7.33	Issue Type +	Ma	Location *	WS
Category	Earthen Levee			GPS Latitude/Longitude	
				Start	End
Item	Encroachments			36.779416 °	36.779416 °
				-120.199091 °	-120.199091 °
DWR ID	DWR_NA0010_24_s_2021_21				
Comment Code					
TR : Tree or limb					
Inspector Comment

Tree limb fallen on the waterside slope. (Spring 2021)

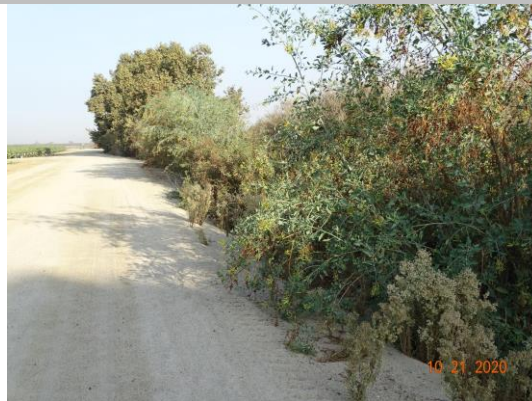
Photo 1 of 1 : FA\_2021\_NA0010\_140\_10\_20210830\_00003.jpg

LM Start	7.35	Rating **	U	Issue No.	10
LM End	7.86	Issue Type +	Ma	Location *	WS
Category	Earthen Levee			GPS Latitude/Longitude	
				Start	End
Item	Vegetation			36.779209 °	36.775239 °
				-120.198886 °	-120.191872 °
DWR ID	DWR_NA0010_24_f _ 2020_10				
Comment Code					
V2 : Remove the wild growth other than native grasses from the levee slopes.					
Inspector Comment

View of the waterside slope looking downstream. (Fall 2020)

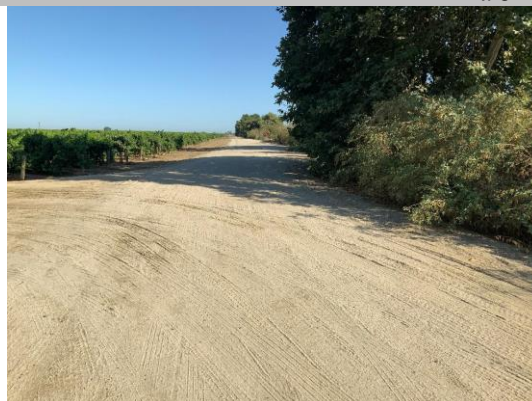
Photo 1 of 3 : UCIP\_FA\_2021\_68923\_102827.jpg

Comment Code					
Inspector Comment					
DS_ID:19958 FS_ID:68923 EP_NO: N/A Repair Type: Non-Urgent EVAL Issue: Limited Inspection/No UCIP Evaluation Crossing Status: Found UCIP Comments: 07/20/2021 The record has been upgraded from No Action Needed to Non-Urgent. Limited inspection due to LS pipe inlet covered by sediment and WS flapgate covered by vegetation debris, recommend clearing out both sides. Levee prism appears to be less than 3 feet in height. No permit was found authorizing this encroachment. CVFPB will need to review crossing to determine owner. The UCIP inspection was completed with GEI staff, P. Espinoza. (H. Dunn – GEI) FIELD_STRUCT_DESC: 12-inch corrugated metal gravity drainage pipe through the levee, 2.5 feet below the crown. Flap gate on the waterside (WS) end. Concrete headwall on each end. [Additional Reference(s): DWR Levee Log, 2002 (HLM 7.63), listed as a 12-inch corrugated metal pipe (CMP)]. FS Date: 7/20/2021

Levee crown.

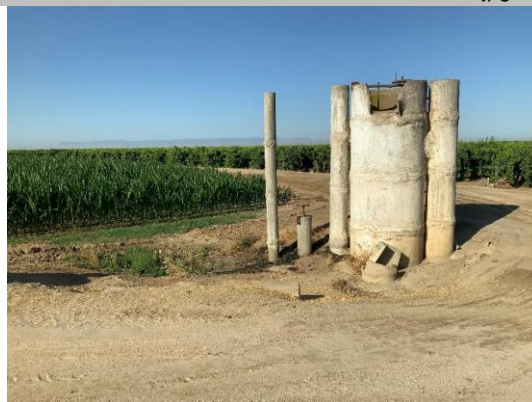
Photo 2 of 3 : UCIP\_FA\_2021\_68923\_102828.jpg

LS view: Headwall just visible at toe from crown.

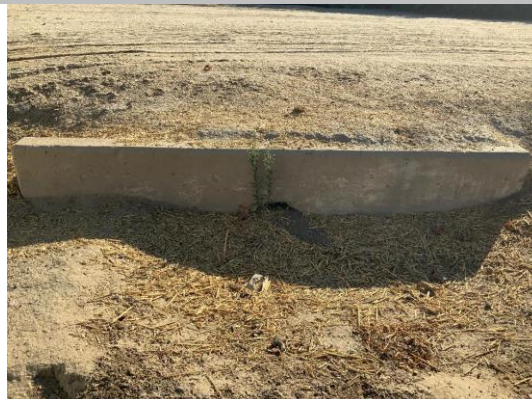
Photo 3 of 3 : UCIP\_FA\_2021\_68923\_102829.jpg

LS view: Headwall and slope from toe.

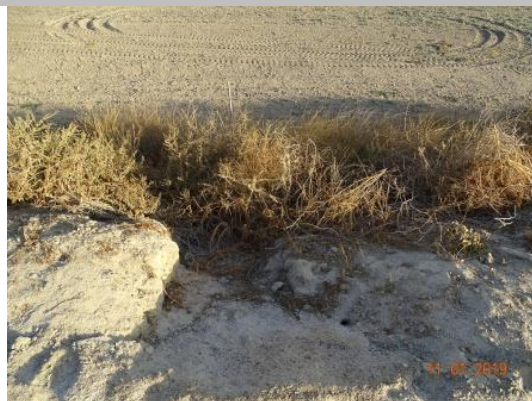
Photo 1 of 1 : FA\_2021\_NA0010\_140\_11\_20210830\_00004.jpg

LM Start	7.83	Rating **	A/W	Issue No.	11
LM End	7.83	Issue Type +	Ma	Location *	WS
Category	Earthen Levee			GPS Latitude/Longitude	
				Start	End
Item	Erosion / Bank Caving			36.775271 °	36.775271 °
				-120.192400 °	-120.192400 °
DWR ID	DWR_NA0010_24_f_2019_11				
Comment Code					
E1 : Note and monitor erosion site.					
Inspector Comment

Looking East down the waterside slope. (Fall 2019)

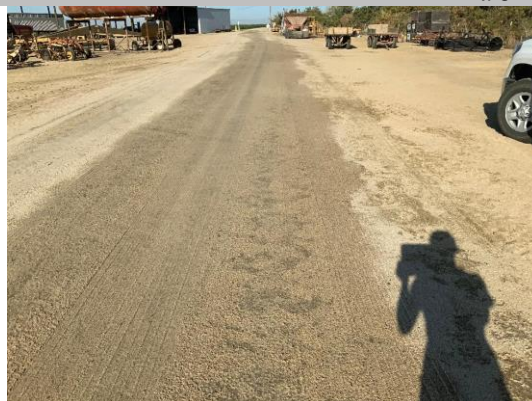
Photo 1 of 3 : UCIP\_FA\_2021\_69551\_102857.jpg

DS\_ID:19959  
FS\_ID:69551  
EP\_NO: N/A  
Repair Type: Non-Urgent  
EVAL Issue: Limited Inspection/No UCIP Evaluation  
Crossing Status: Indicator Found  
UCIP Comments: 07/20/2021 The record is Non-Urgent. Possible WS headwall visible from the crown but inaccessible due to fences, limited inspection. Appears removed or abandoned due to no cobble outlet channel or outlet visible on the LS. LS end is completely flat and adjacent to a working farm. DWR DMP geophysical study did not confirm presence of pipe through levee. Record will remain in UCIP's inspection records until future Levee Improvement Project can confirm no crossing was found through the levee. No permit was found authorizing this encroachment. CVFPB will need to review crossing to determine owner. Levee prism appears to be less than 3 feet in height. The UCIP inspection was completed with GEI staff, P. Espinoza. (H. Dunn – GEI)

Levee crown.

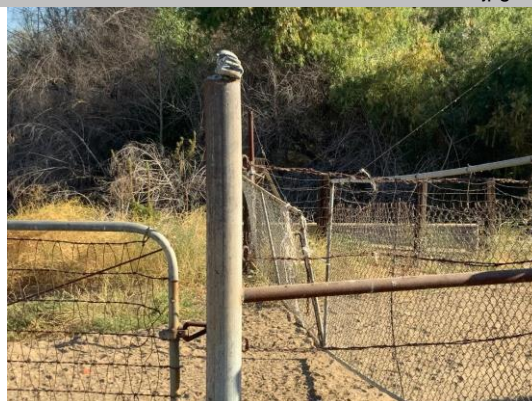
Photo 2 of 3 : UCIP\_FA\_2021\_69551\_102856.jpg

LS view: Top of a headwall barely visible behind fences from crown.

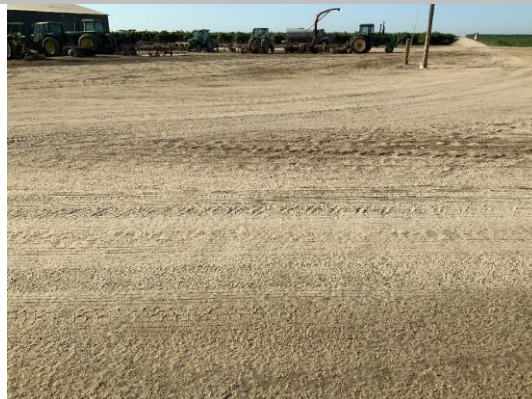
Photo 3 of 3 : UCIP\_FA\_2021\_69551\_102858.jpg

WS view: Toe from crown, no pipe visible.

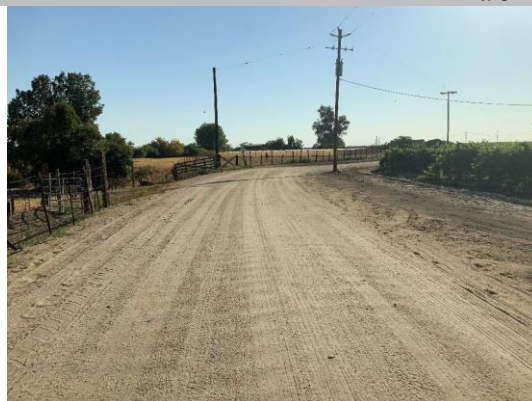
Photo 1 of 3 : UCIP\_FA\_2021\_68925\_102859.jpg

DS\_ID:19960  
 FS\_ID:68925  
 EP\_NO: N/A  
 Repair Type: Non-Urgent  
 EVAL Issue: Limited Inspection/No UCIP Evaluation  
 Crossing Status: Found  
 UCIP Comments: 07/20/2021 The record remains Non-Urgent. WS outlet filled with sediment, recommend cleaning out. LS pipe inlet not found, likely buried under dirt, recommend removal. No permit was found authorizing this encroachment. CVFPB will need to review crossing to determine owner. Levee prism appears to be less than 3 feet in height. The UCIP inspection was completed with GEI staff, P. Espinoza. (H. Dunn – GEI) 04/08/2014 Barbed wire along levee shoulder--no access. Need to confirm crossing size and condition of crossing. (O. Magana - DWR UCIP)  
 FIELD\_STRUCT\_DESC: 12-inch reinforced concrete gravity drainage pipe through the levee, 3 feet below the crown. Flap gate on the waterside (WS) end. Concrete headwall on the WS end. [Additional Reference(s): DWR Levee Log, 2002 (HLM 8.33), listed as a 12-inch concrete pipe. USACE San Joaquin O&M Manual, Unit 601 Part 1 (SJR601.1), 1967, Revised 25 May 2011, (HLM 8.32), listed as a 12-inch concrete pipe]

Levee crown.

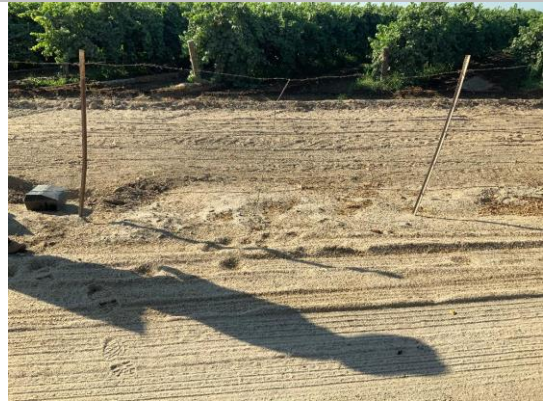
Photo 2 of 3 : UCIP\_FA\_2021\_68925\_102863.jpg

LS view: Toe from crown, no pipe visible.

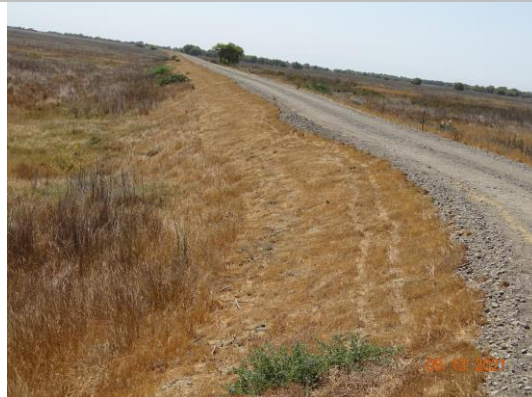
Photo 1 of 1 : FA\_2021\_NA0010\_141\_7\_20211008\_00020.jpg

LM Start	0.00	Rating **	A	Issue No.	7
LM End	0.00	Issue Type +	Ma	Location *	LS
Category	Earthen Levee			GPS Latitude/Longitude	
				Start	End
Item	Vegetation			37.296282 °	37.296282 °
				-120.880694 °	-120.880694 °
DWR ID	DWR_NA0010_25_f _ 2021_7				
Comment Code					
V1 : Control annual grass and weeds on the levee slopes and easements.					
Inspector Comment

Looking upstream along the landside slope. (Fall 2021)

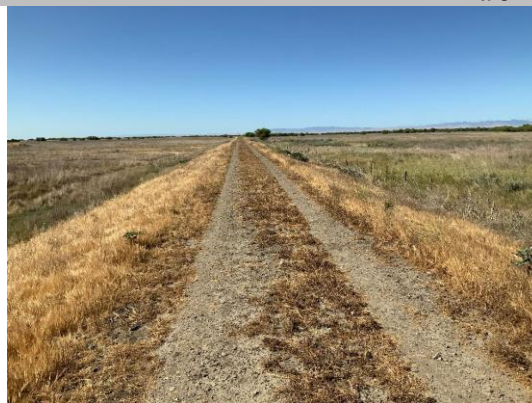
Photo 1 of 3 : UCIP\_FA\_2021\_68238\_100680.jpg

Comment Code						
Inspector Comment						
DS_ID:19965 FS_ID:68238 EP_NO: N/A Repair Type: Non-Urgent EVAL Issue: Maintenance Compliance Issue Crossing Status: Found UCIP Comments: 06/8/2021 The record remains Non-Urgent. Landside (LS) pipe inlet has some vegetation and sediment buildup, recommend cleaning out. No permit was found authorizing this encroachment. CVFPB will need to review crossing to determine owner. The UCIP inspection was completed with GEI staff, P. Espinoza. (H. Dunn – GEI)  05/01/2014 Dense vegetation limits the inspectors visibility to identify signs of pipe failure (leaks) along the slope. Recommend removing vegetation along pipe alignment to conduct proper inspection of structure. Sediment buildup in pipe visible from landward side-- recommend clearing. (O. Magana - DWR UCIP) FIELD_STRUCT_DESC: 24-inch corrugated metal gravity drainage pipe through the levee, 10 feet below the crown. Flap gate on the waterside (WS) end. [Additional Reference(s): DWR Levee Log, 2002 (HLM 0.01), listed as a 24-inch corrugated metal pipe (CMP). USACE San Joaquin O&M Manual, Unit 601 Part 1 (SJR601.1), 1967, Revised 25 May 2011, (HLM 0.02), listed as a 24-inch CMP] FS Date: 6/8/2021

Levee crown looking upstream.

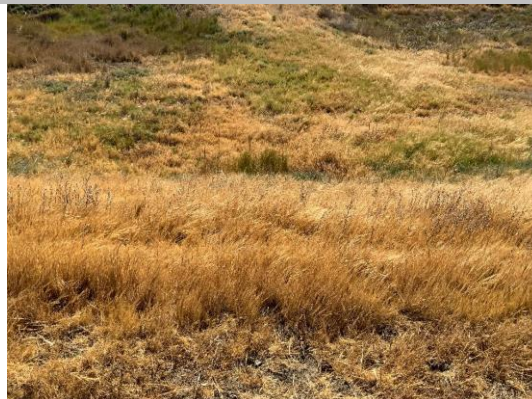
Photo 2 of 3 : UCIP\_FA\_2021\_68238\_100681.jpg

LS view: Toe from crown.

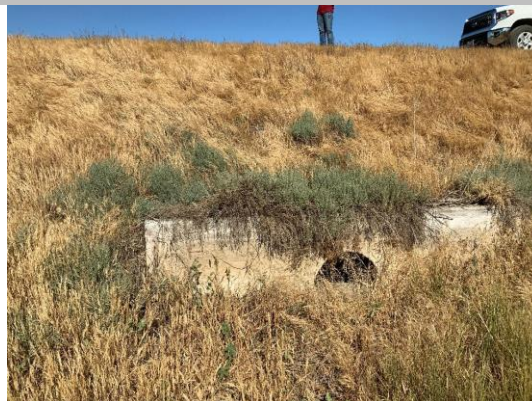
Photo 3 of 3 : UCIP\_FA\_2021\_68238\_100682.jpg

LS view: Slope and headwall from toe.

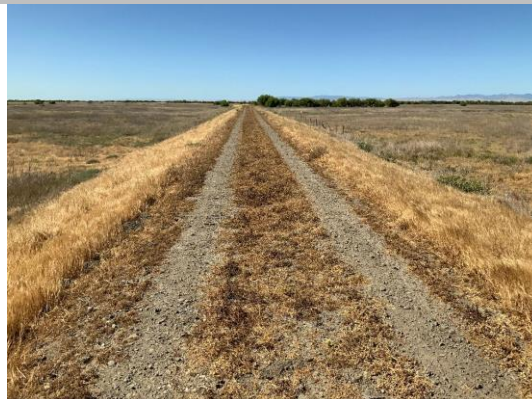
Photo 1 of 3 : UCIP\_FA\_2021\_68240\_100698.jpg

Comment Code						
Inspector Comment						
DS_ID:19966 FS_ID:68240 EP_NO: N/A Repair Type: Non-Urgent EVAL Issue: Limited Inspection/No UCIP Evaluation Crossing Status: Found UCIP Comments: 06/8/2021 The record remains Non-Urgent. Dense LS vegetation over pipe inlet and headwall, recommend removal. No permit was found authorizing this encroachment. CVFPB will need to review crossing to determine owner. The UCIP inspection was completed with GEI staff, P. Espinoza. (H. Dunn – GEI) 05/01/2014 Dense vegetation limits the inspectors visibility to identify signs of pipe failure (leaks) along the slope. Recommend removing vegetation along pipe alignment to conduct proper inspection of structure. (O. Magana - DWR UCIP) FIELD_STRUCT_DESC: 24-inch corrugated metal gravity drainage pipe through the levee, 11.6 feet below the crown. Flap gate on the waterside (WS) end. [Additional Reference(s): DWR Levee Log, 2002 (HLM 0.36), listed as a 24-inch corrugated metal pipe (CMP). USACE San Joaquin O&M Manual, Unit 601 Part 1 (SJR601.1), 1967, Revised 25 May 2011, (HLM 0.35), listed as a 24-inch CMP]. FS Date: 6/8/2021

Levee crown looking upstream.

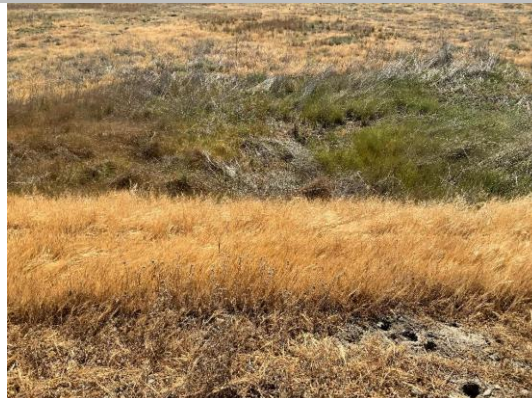
Photo 2 of 3 : UCIP\_FA\_2021\_68240\_100699.jpg

LS view: Toe from crown.

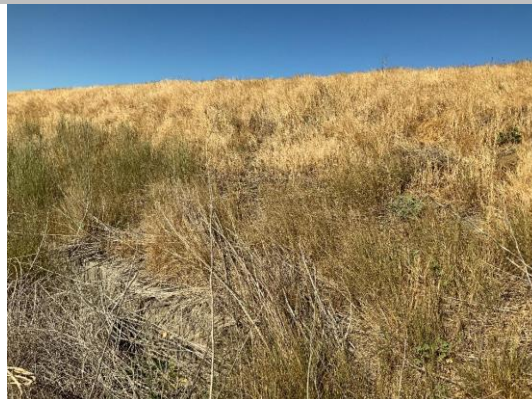
Photo 3 of 3 : UCIP\_FA\_2021\_68240\_100700.jpg

LS view: Slope from toe.

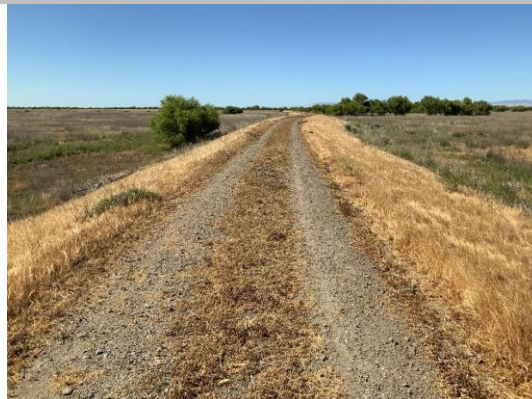
Photo 1 of 3 : UCIP\_FA\_2021\_67743\_100705.jpg

DS\_ID:19967  
 FS\_ID:67743  
 EP\_NO: N/A  
 Repair Type: Non-Urgent  
 EVAL Issue: Limited Inspection/No UCIP Evaluation  
 Crossing Status: Found  
 UCIP Comments: 06/8/2021 The record remains Non-Urgent. Dense LS vegetation, recommend removal around pipe inlet. No permit was found authorizing this encroachment. CVFPB will need to review crossing to determine owner. The UCIP inspection was completed with GEI staff, P. Espinoza. (H. Dunn – GEI) 05/01/2014 Dense vegetation limits the inspectors visibility to identify signs of pipe failure (leaks) along the slope. Recommend removing vegetation along pipe alignment to conduct proper inspection of structure. (O. Magana - DWR UCIP)  
 FIELD\_STRUCT\_DESC: 24-inch corrugated metal gravity drainage pipe through the levee, 14.7 feet below the crown. Flap gate on the waterside (WS) end. [Additional Reference(s): DWR Levee Log, 2002 (HLM 0.58), listed as a 24-inch corrugated metal pipe (CMP). USACE San Joaquin O&M Manual, Unit 601 Part 1, (SJR601.1), 1967, Revised 25 May 2011, (HLM 0.59), listed as a 24-inch CMP].

Levee crown looking upstream.

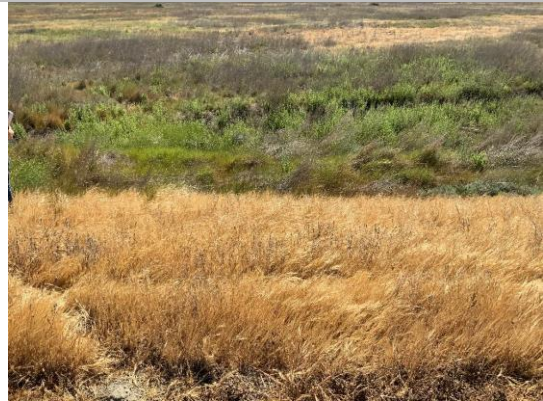
Photo 2 of 3 : UCIP\_FA\_2021\_67743\_100710.jpg

LS view: Toe from crown.

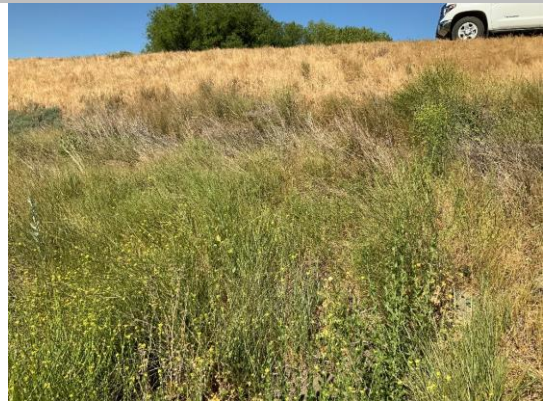
Photo 3 of 3 : UCIP\_FA\_2021\_67743\_100703.jpg

LS view: Slope from toe.

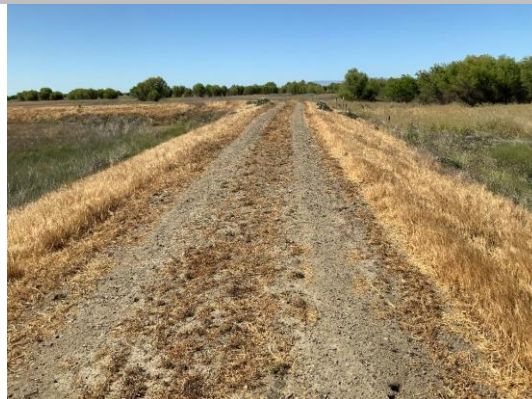
Photo 1 of 3 : UCIP\_FA\_2021\_67745\_100717.jpg

DS\_ID:19968  
FS\_ID:67745  
EP\_NO: N/A  
Repair Type: Non-Urgent  
EVAL Issue: Limited Inspection/No UCIP Evaluation  
Crossing Status: Found  
UCIP Comments: 06/8/2021 The record remains Non-Urgent. Dense LS vegetation over pipe inlet, recommend removal. Lots of small burrow holes all along the crown and along the sides, recommend filling in. No permit was found authorizing this encroachment. CVFPB will need to review crossing to determine owner. The UCIP inspection was completed with GEI staff, P. Espinoza. (H. Dunn – GEI) 05/01/2014 Dense vegetation limits the inspectors visibility to identify signs of pipe failure (leaks) along the slope. Recommend removing vegetation along pipe alignment to conduct proper inspection of structure. (O. Magana - DWR UCIP)  
FIELD\_STRUCT\_DESC: 24-inch corrugated metal gravity drainage pipe through the levee, 11.4 feet below the crown. Flap gate on the waterside (WS) end. [Additional Reference(s): DWR Levee Log, 2002 (HLM 0.97), listed as a 24-inch corrugated metal pipe (CMP). USACE San Joaquin O&M Manual, Unit 601 Part 1 (SJR601.1), 1967, Revised 25 May 2011, (HLM 0.97), listed as a 24-inch CMP]

Levee crown looking downstream.

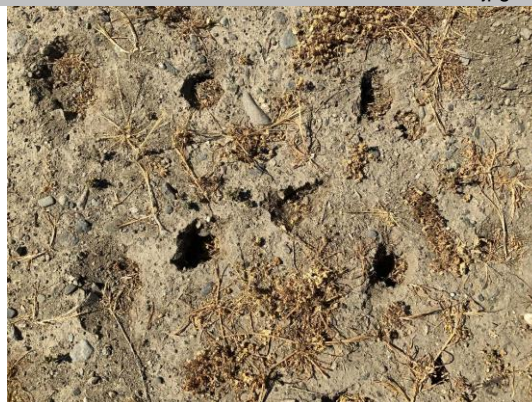
Photo 2 of 3 : UCIP\_FA\_2021\_67745\_100718.jpg

Crown: Small burrow holes along the crown, 1 of 2 photos.

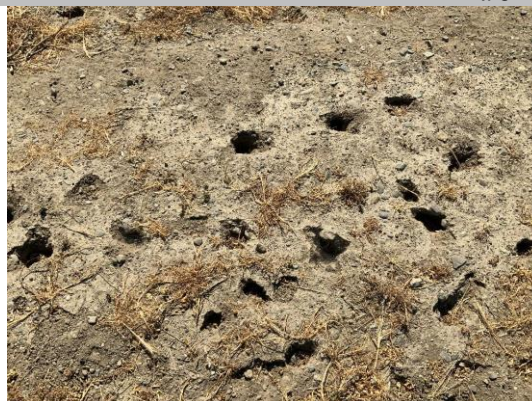
Photo 3 of 3 : UCIP\_FA\_2021\_67745\_100716.jpg

Crown: Small burrow holes on the top of the levee, 2 of 2 photos.

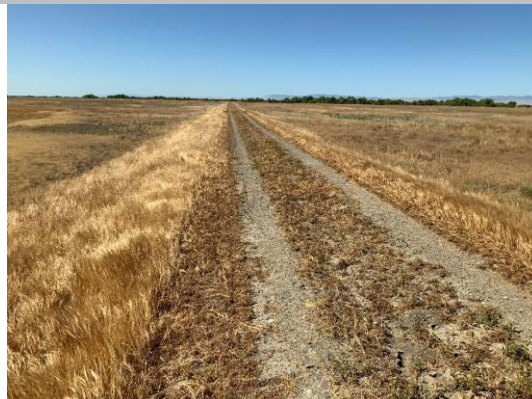
Photo 1 of 3 : UCIP\_FA\_2021\_67747\_100729.jpg

DS\_ID:19969  
FS\_ID:67747  
EP\_NO: N/A  
Repair Type: Non-Urgent  
EVAL Issue: Limited Inspection/No UCIP Evaluation  
Crossing Status: Found  
UCIP Comments: 06/8/2021 The record remains Non-Urgent. Levee prism appears to be around or slightly less than 3 feet. Dense vegetation on LS pipe inlet, recommend removal. No permit was found authorizing this encroachment. CVFPB will need to review crossing to determine owner. The UCIP inspection was completed with GEI staff, P. Espinoza. (H. Dunn – GEI) 05/01/2014 Dense vegetation limits the inspectors visibility to identify signs of pipe failure (leaks) along the slope. Recommend removing vegetation along pipe alignment to conduct proper inspection of structure. (O. Magana - DWR UCIP)  
FIELD\_STRUCT\_DESC: 24-inch corrugated metal gravity drainage pipe through the levee, 4 feet below the crown. Flap gate on the waterside (WS) end. [Additional Reference(s): DWR Levee Log, 2002 (HLM 2.05), listed as a 24-inch corrugated metal pipe (CMP). USACE San Joaquin O&M Manual, Unit 601 Part 1 (SJR601.1), 1967, Revised 25 May 2011, (HLM 2.05), listed as a 24-inch CMP]

Levee crown looking upstream.

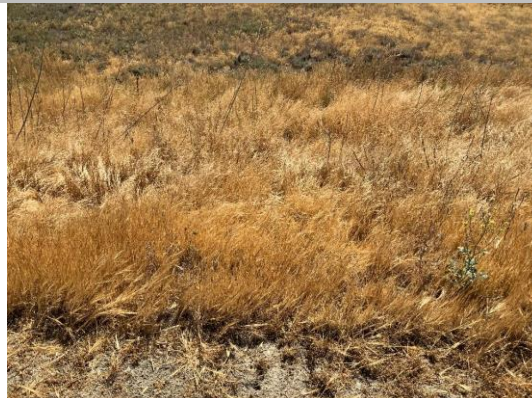
Photo 2 of 3 : UCIP\_FA\_2021\_67747\_100730.jpg

LS view: Toe from crown.

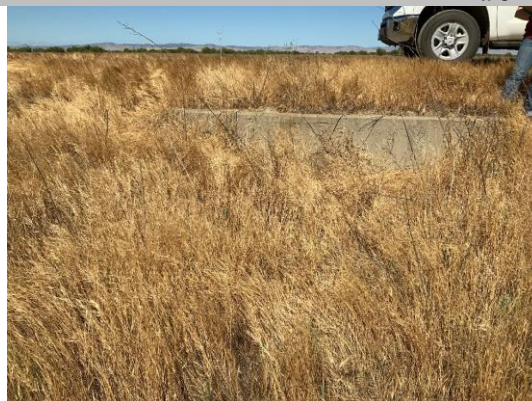
Photo 3 of 3 : UCIP\_FA\_2021\_67747\_100731.jpg

LS view: Headwall barely visible from toe.

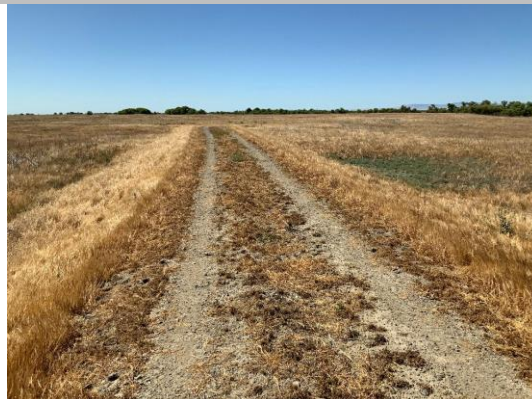
Photo 1 of 3 : UCIP\_FA\_2021\_68241\_100735.jpg

Comment Code					
Inspector Comment					
DS_ID:19970 FS_ID:68241 EP_NO: N/A Repair Type: Urgent EVAL Issue: Pipe Integrity Crossing Status: Found UCIP Comments: 06/8/2021 Record has been upgraded from Non-Urgent to Urgent. External inspection in the field has found pipe integrity issues. WS pipe end is rusted with multiple large deteriorated holes under and around the flapgate. Rusting and peeling of metal and liner inside the LS pipe inlet. Also sediment buildup inside LS inlet, recommend cleaning out and recommend monitoring crossing until funding becomes available to address the issues. No permit was found authorizing this encroachment. CVFPB will need to review crossing to determine owner. The UCIP inspection was completed with GEI staff, P. Espinoza. (H. Dunn – GEI)05/01/2014 Dense vegetation limits the inspectors visibility to identify signs of pipe failure (leaks) along the slope. Recommend removing vegetation along pipe alignment to conduct proper inspection of structure. Sediment buildup in pipe visible on landward side--recommend clearing. (O. Magana - DWR UCIP) FIELD_STRUCT_DESC: 24-inch corrugated metal gravity drainage pipe through the levee, 11.2 feet below the crown. Flap gate on the waterside (WS) end. [Additional Reference(s): DWR Levee Log, 2002 (HLM 2.45), listed as a 24-inch corrugated metal pipe (CMP). USACE San Joaquin O&M Manual, Unit 601 Part 1 (SJR601.1), 1967, Revised 25 May 2011, (HLM 2.45), listed as a 24-inch CMP] FS Date: 6/8/2021

Levee crown looking upstream.

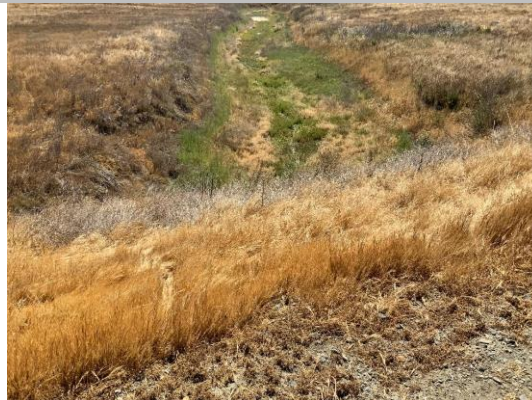
Photo 2 of 3 : UCIP\_FA\_2021\_68241\_100736.jpg

LS view: Toe from crown.

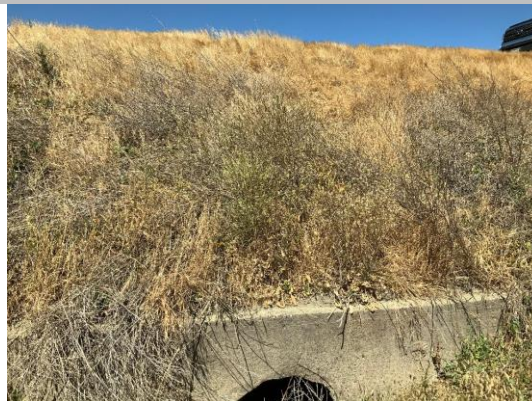
Photo 3 of 3 : UCIP\_FA\_2021\_68241\_100737.jpg

LS view: Headwall and slope from toe.
