Flood Control Project Maintenance Levee Inspections

Fall 2022 Levee Maintenance Deficiency Summary Report

San Joaquin River Basin

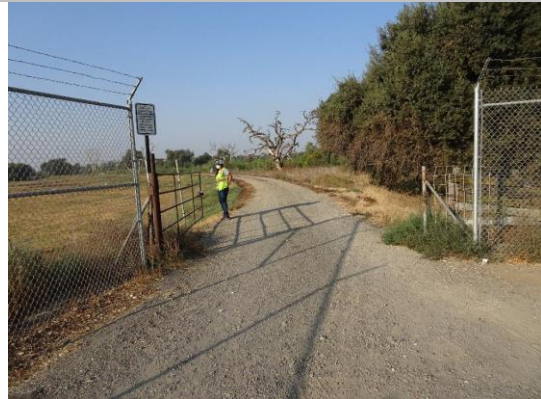
Photo 1 of 3 : UCIP_FA_2022_70636_92086.jpg

Comment Code						
Inspector Comment						
DS_ID:19650 FS_ID:70636 EP_NO: N/A Repair Type: Non-Urgent EVAL Issue: 5, Pipe Damage Crossing Status: Found UCIP Comments: 10/06/2020 Record remains Non-Urgent. DWR DMP has found integrity issues, LOF between 4 and 5. This crossing will be monitored until funding becomes available for rehabilitation. Dense vegetation was found along the LS and WS. No permit was found authorizing this encroachment. The CVFPB will need to review crossing to determine owner. (O. Magana - DWR UCIP, B. Singh - GEI)04/08/2014 Dense vegetation limits the inspector's visibility to identify signs of pipe failure (leaks) along the waterward slope and landward toe. Recommend removing vegetation along pipe alignment and landward toe to conduct proper inspection of structure and appurtenances. (W. Wylie - DWR UCIP) FIELD_STRUCT_DESC: 24-inch corrugated metal (CM) gravity drainage pipe through the levee, 10.5 feet below the crown. Flap gate on the waterside (WS) end. Brass cap No. 108 bench mark (BM) on the headwall on the landside (LS), elevation 65.1 feet, USGS Datum. [Additional Reference(s): DWR Levee Log, 2002, (HLM 0.00). USACE San Joaquin O&M Manual, Unit No. 601, Part No. 1, (SJR601.1), 1967, Revised 25 May 2011, (HLM 0.02)]. FS Date: 10/6/2020

Overview of levee crown looking upstream towards pipe crossing. Pipe is locate near gate entrance.

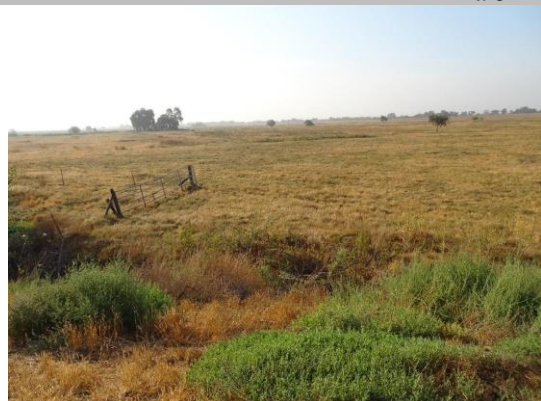
Photo 2 of 3 : UCIP_FA_2022_70636_92088.jpg

LS view: overview of LS, dense vegetation on slope and levee toe.

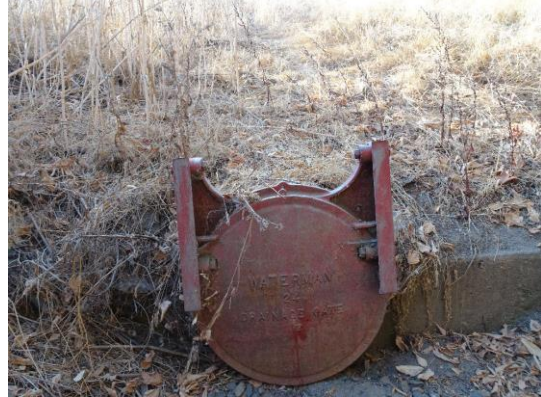
Photo 3 of 3 : UCIP_FA_2022_70636_92089.jpg

WS view: gate visible on the WS toe with concrete wall supporting pipe.

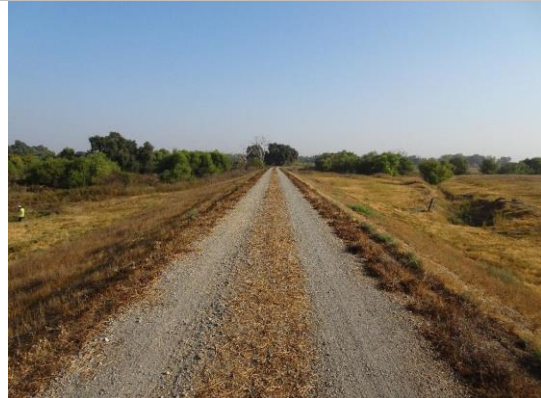
Photo 1 of 3 : UCIP_FA_2022_70637_90529.jpg

DS_ID:19651
FS_ID:70637
EP_NO: N/A
Repair Type: Non-Urgent
EVAL Issue: 11, Maintenance Compliance Issue
Crossing Status: Found
UCIP Comments: 10/06/2020 Record remains Non-Urgent. No permit was found authorizing this encroachment. Sediment buildup found on the LS. Recommend maintenance to clear up sediment buildup along pipe invert. CVFPB will need to review crossing to determine owner. DWR DMP internal inspection is pending and scheduled for 2021. (O. Magana - DWR UCIP, B. Singh - GEI)04/08/2014 Pipe has significant sediment buildup and shows some signs of corrosion at landward toe. Recommend cleaning sediment from inside pipe and check wall integrity. (W. Wylie - DWR UCIP)
FIELD_STRUCT_DESC: 36-inch corrugated metal (CM) gravity drainage pipe through the levee, 18.5 feet below the crown. Flap gate on the waterside (WS) end. Brass cap No. 108 bench mark (BM) on the headwall on the landside (LS). [Additional Reference(s): DWR Levee Log, 2002, (HLM 0.35). USACE San Joaquin O&M Manual, Unit No. 601, Part No. 1, (SJR601.1), 1967, Revised 25 May 2011, (HLM 0.35)].

Overview of levee looking US

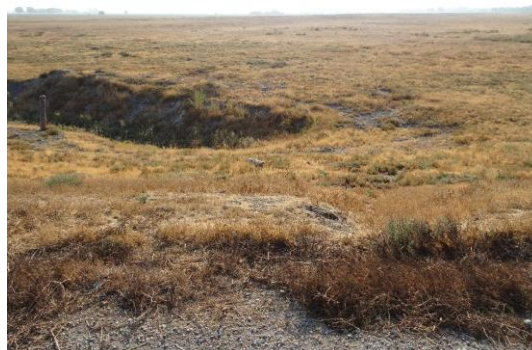
Photo 2 of 3 : UCIP_FA_2022_70637_90530.jpg

LS view: Overview of LS from levee crest, looking US

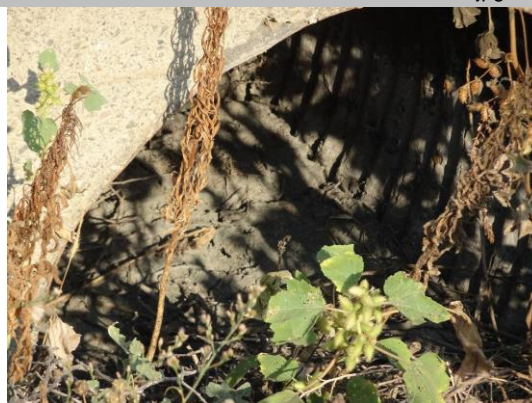
Photo 3 of 3 : UCIP_FA_2022_70637_92300.jpg

LS view: sediment build up along the pipe invert.

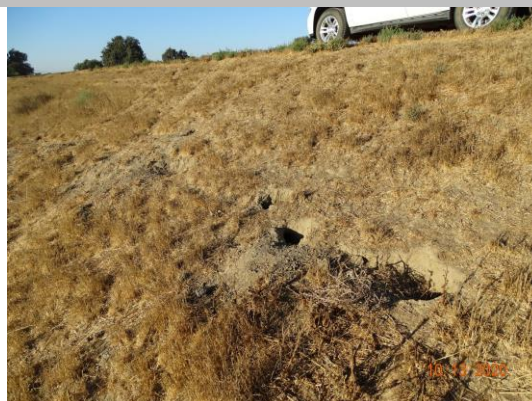
Photo 1 of 1 : FA_2022_NA0010_118_95_20220822_00005.jpg

LM Start	0.36	Rating **	M	Issue No.	95
LM End	0.36	Issue Type +	Ma	Location *	LS
Category	Earthen Levee			GPS Latitude/Longitude	
				Start	End
Item	Animal Control			37.344312 °	37.344312 °
				-120.962361 °	-120.962361 °
DWR ID	DWR_NA0010_01_f_2020_95				
Comment Code					
A3 : No rodents visible, but rodent burrows visible; need to backfill and compact or grout burrows.					
Inspector Comment

Several rodent holes observed in the landside slope. (Fall 2020)

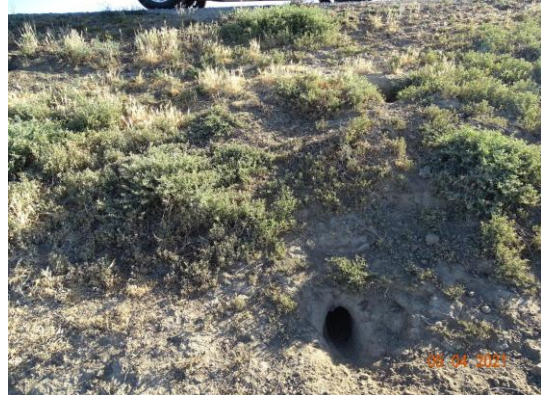
Photo 1 of 1 : FA_2022_NA0010_118_97_20220822_00006.jpg

LM Start	0.45	Rating **	M	Issue No.	97
LM End	0.45	Issue Type +	Ma	Location *	WS
Category	Earthen Levee			GPS Latitude/Longitude	
				Start	End
Item	Animal Control			37.343243 °	37.343243 °
				-120.962159 °	-120.962159 °
DWR ID	DWR_NA0010_01_s_2021_97				
Comment Code					
A1 : Exterminate rodents and backfill and compact or grout burrows.					
Inspector Comment

View of rodent burrows in the waterside slope. (Spring 2021)

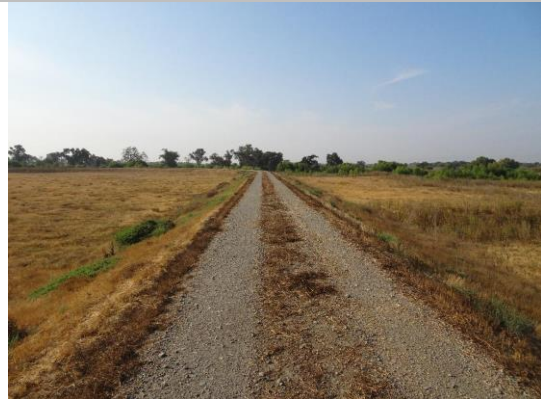
Photo 1 of 3 : UCIP_FA_2022_70638_90537.jpg

Comment Code					
Inspector Comment					
DS_ID:19583 FS_ID:70638 EP_NO: N/A Repair Type: Non-Urgent EVAL Issue: Crossing Status: Found UCIP Comments: 10/06/2020 Record remains Non-Urgent. No permit was found authorizing this encroachment. Rodent activity found near pipe location. CVFPB will need to review crossing to determine owner. DWR DMP has not found internal issues, LOF between 1 and 2. Recommend inspection in 5 years. (B. Singh - GEI, O. Magana - DWR UCIP)04/08/2014 Recommend removing vegetation pile from waterward toe. (W. Wylie - DWR UCIP) FIELD_STRUCT_DESC: 24-inch corrugated metal (CM) gravity drainage pipe through the levee, 8.5 feet below the crown. Flap gate on the waterside (WS) end. Brass cap No. 108 bench mark (BM) on the headwall on the landside (LS). [Additional Reference(s): DWR Levee Log, 2002, (HLM 0.62). USACE San Joaquin O&M Manual, Unit No. 601, Part No. 1, (SJR601.1), 1967, Revised 25 May 2011, (HLM 0.62)]. FS Date: 10/6/2020

Overview of levee crown, looking US

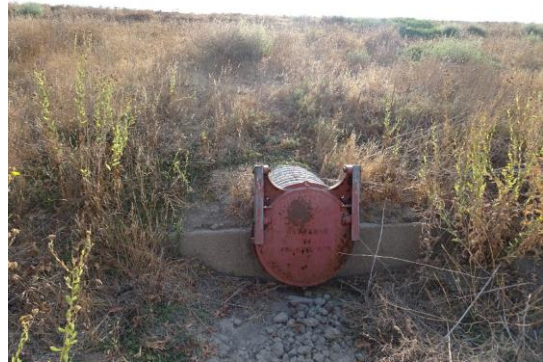
Photo 2 of 3 : UCIP_FA_2022_70638_90535.jpg

WS view: Flapgate and headwall at WS toe

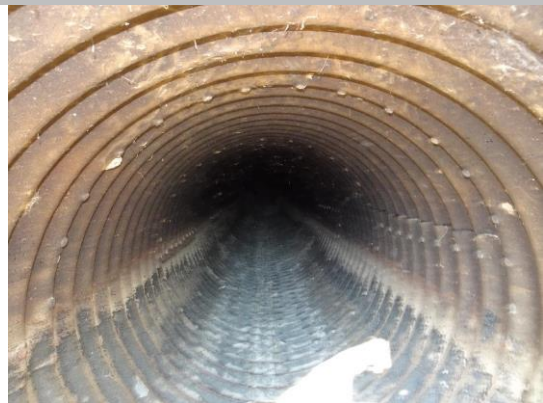
Photo 3 of 3 : UCIP_FA_2022_70638_90540.jpg

LS view: Inside pipe from LS toe

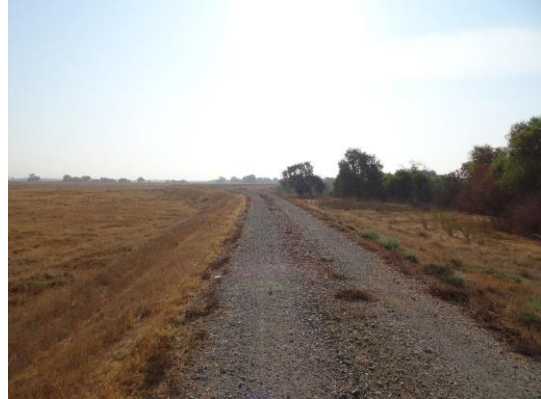
Photo 1 of 3 : UCIP_FA_2022_70639_90541.jpg

Comment Code					
Inspector Comment					
DS_ID:19584 FS_ID:70639 EP_NO: N/A Repair Type: Non-Urgent EVAL Issue: Crossing Status: Found UCIP Comments: 10/06/2020 Record has been updated from No Action Needed to Non-Urgent. No permit was found authorizing this encroachment. CVFPB will need to review crossing to determine owner. Rodent activity found near this stretch of levee. DWR DMP has not found internal issues, LOF between 1 and 2. Recommend inspection in 5 years. (B. Singh - GEI, O. Magana - DWR UCIP) FIELD_STRUCT_DESC: 24-inch corrugated metal (CM) gravity drainage pipe through the levee, 7.0 feet below the crown. Flap gate on the waterside (WS) end. Brass cap No. 108 bench mark (BM) on the headwall on the landside (LS). [Additional Reference(s): DWR Levee Log, 2002, (HLM 0.88). USACE San Joaquin O&M Manual, Unit No. 601, Part No. 1, (SJR601.1), 1967, Revised 25 May 2011, (HLM 0.87)]. FS Date: 10/6/2020

Overview of levee crown, looking US

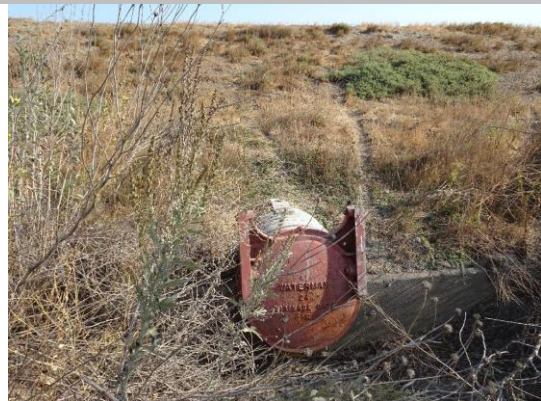
Photo 2 of 3 : UCIP_FA_2022_70639_90546.jpg

WS view: Pipe, flapgate, and headwall at WS toe

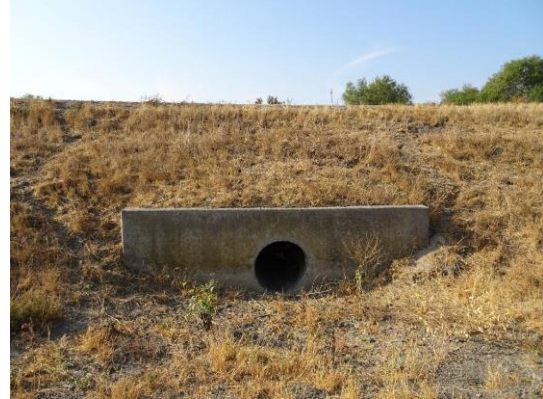
Photo 3 of 3 : UCIP_FA_2022_70639_90544.jpg

LS view: Pipe and headwall at LS toe

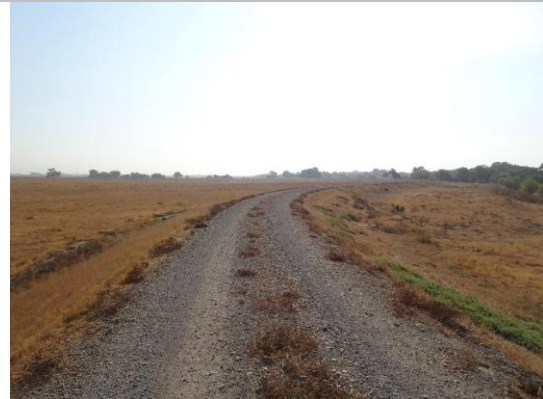
Photo 1 of 3 : UCIP_FA_2022_70640_90550.jpg

DS_ID:19585
 FS_ID:70640
 EP_NO: N/A
 Repair Type: Urgent
 EVAL Issue: 1, Pipe Integrity
 Crossing Status: Found
 UCIP Comments: 10/06/2020 Record has been updated from Non-Urgent to Urgent. DWR DMP has found integrity issues, LOF between 5 and 6. Scour visible behind the concrete headwall on the LS toe. Recommend monitoring crossing until funding becomes available to addressed. No permit was found authorizing this encroachment. CVFPB will need to review crossing to determine owner. (B. Singh - GEI, O. Magana - DWR UCIP)04/08/2014 Moderate erosion around headwall on landward toe. May or may not be an issue. Need to contact owner to determine status of crossing and to address erosion issue on landward side. (W. Wylie - DWR UCIP)
 FIELD_STRUCT_DESC: 24-inch corrugated metal (CM) gravity drainage pipe through the levee, 9.0 feet below the crown. Flap gate on the waterside (WS) end. Brass cap No. 108 bench mark (BM) on the headwall on the landside (LS). [Additional Reference(s): DWR Levee Log, 2002, (HLM 0.96). USACE San Joaquin O&M Manual, Unit No. 601, Part No. 1, (SJR601.1), 1967, Revised 25 May 2011, (HLM 0.95)].

Overview of levee crown, looking US

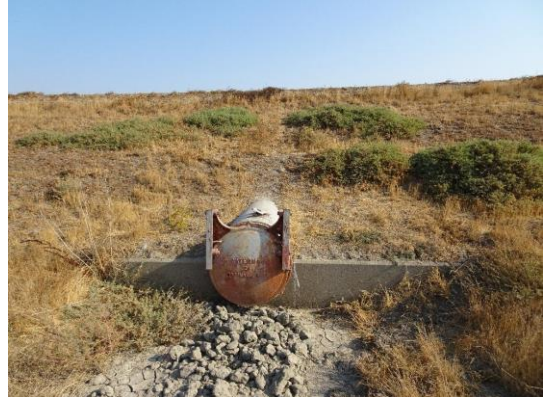
Photo 2 of 3 : UCIP_FA_2022_70640_90547.jpg

WS view: Flapgate, pipe, and headwall on WS toe

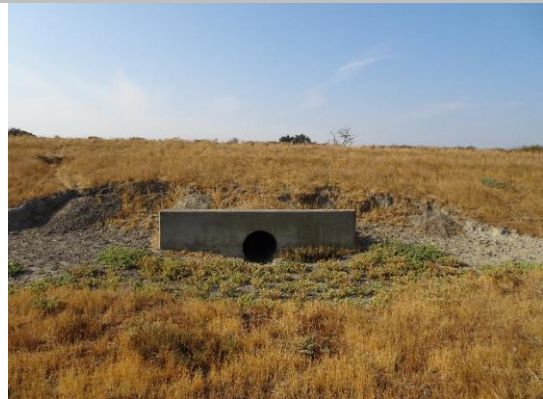
Photo 3 of 3 : UCIP_FA_2022_70640_90548.jpg

LS view: Headwall and pipe on LS toe. Significant scour surrounding headwall

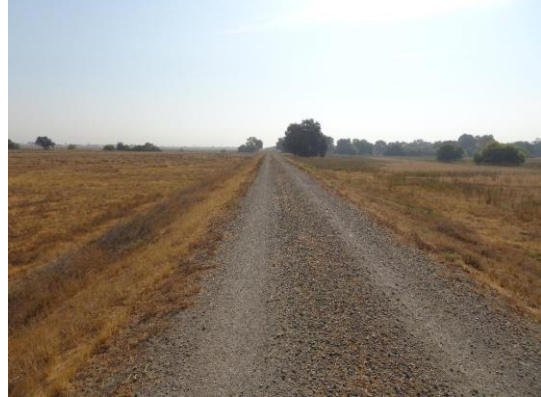
Photo 1 of 3 : UCIP_FA_2022_70641_90554.jpg

Comment Code					
Inspector Comment					
DS_ID:19586 FS_ID:70641 EP_NO: N/A Repair Type: Non-Urgent EVAL Issue: Crossing Status: Found UCIP Comments: 10/06/2020 Record has been updated from No Action Needed to Non-Urgent. No permit was found authorizing this encroachment. CVFPB will need to review crossing to determine owner. DWR DMP has not found internal issues, LOF between 1 and 2. Recommend inspection in 5 years. (B. Singh - GEI, O. Magana - DWR UCIP) FIELD_STRUCT_DESC: 24-inch corrugated metal (CM) gravity drainage pipe through the levee, 7.5 feet below the crown. Flap gate on the waterside (WS) end. Brass cap No. 108 bench mark (BM) on the headwall on the landside (LS). [Additional Reference(s): DWR Levee Log, 2002, (HLM 1.18). USACE San Joaquin O&M Manual, Unit No. 601, Part No. 1, (SJR601.1), 1967, Revised 25 May 2011, (HLM 1.17)]. FS Date: 10/6/2020

Overview of levee crown, looking US

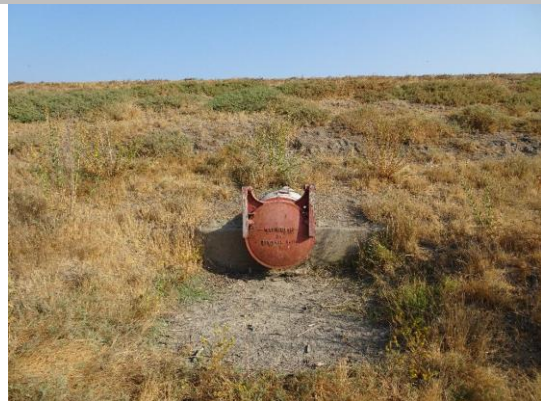
Photo 2 of 3 : UCIP_FA_2022_70641_90553.jpg

Pipe, flapgate and headwall on WS toe

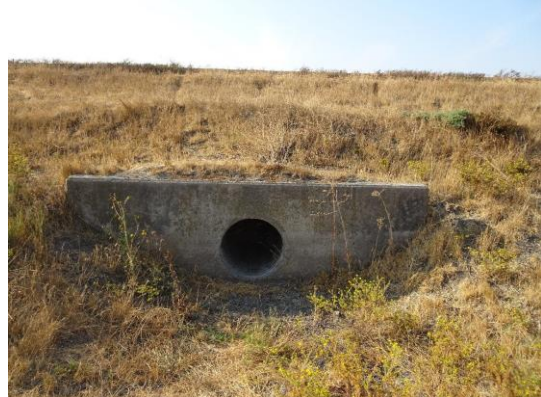
Photo 3 of 3 : UCIP_FA_2022_70641_90557.jpg

Headwall and pipe at LS toe

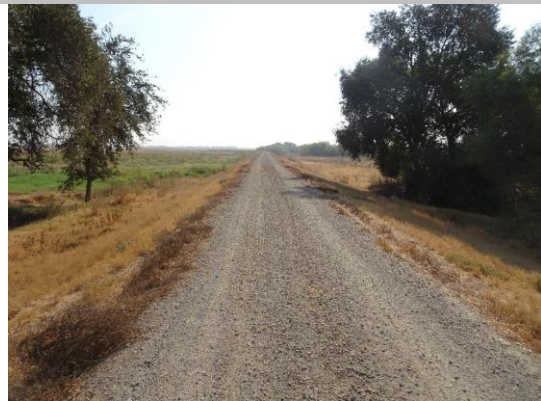
Photo 1 of 3 : UCIP_FA_2022_70642_90560.jpg

Overview of levee crown, looking US

Comment Code					
Inspector Comment					
DS_ID:19587 FS_ID:70642 EP_NO: N/A Repair Type: Non-Urgent EVAL Issue: Crossing Status: Found UCIP Comments: 10/06/2020 Record has been updated from No Action Needed to Non-Urgent. No permit was found authorizing this encroachment. CVFPB will need to review crossing to determine owner. DWR DMP internal inspection is still pending and scheduled for 2021. (B. Singh - GEI, O. Magana - DWR UCIP) FIELD_STRUCT_DESC: 36-inch corrugated metal (CM) gravity drainage pipe through the levee, 12.8 feet below the crown. Flap gate on the waterside (WS) end. Brass cap No. 108 bench mark (BM) on the headwall on the landside (LS). Pipe crosses through the levee at about a 45-degree angle. [Additional Reference(s): DWR Levee Log, 2002, (HLM 1.35). USACE San Joaquin O&M Manual, Unit No. 601, Part No. 1, (SJR601.1), 1967, Revised 25 May 2011, (HLM 1.34)]. FS Date: 10/6/2020

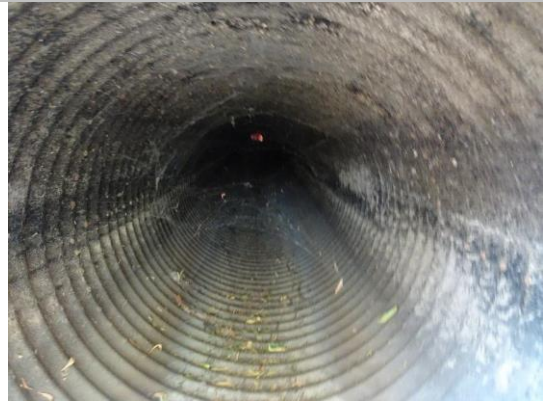
Photo 2 of 3 : UCIP_FA_2022_70642_90562.jpg

LS view: Inside pipe at LS toe

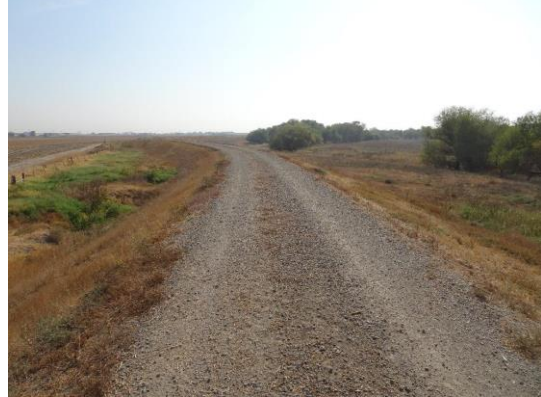
Photo 1 of 3 : UCIP_FA_2022_70643_90567.jpg

Comment Code						
Inspector Comment						
DS_ID:19588 FS_ID:70643 EP_NO: N/A Repair Type: Non-Urgent EVAL Issue: Crossing Status: Found UCIP Comments: 10/06/2020 Record remains Non-Urgent. No permit was found authorizing this encroachment. CVFPB will need to review crossing to determine owner. DWR DMP has not found internal issues, LOF between 1 and 2. Recommend inspection in 5 years. (B. Singh - GEI, O. Magana - DWR UCIP)04/08/2014 Some sediment buildup inside pipe at LS toe. Recommend contacting owner to clear sediment buildup and check wall integrity through pipe section. (W. Wylie - DWR UCIP) FIELD_STRUCT_DESC: 24-inch corrugated metal (CM) gravity drainage pipe through the levee, 11.0 feet below the crown. Flap gate on the waterside (WS) end. Brass cap No. 108 bench mark (BM) on the headwall on the landside (LS). [Additional Reference(s): DWR Levee Log, 2002, (HLM 1.48). USACE San Joaquin O&M Manual, Unit No. 601, Part No. 1, (SJR601.1), 1967, Revised 25 May 2011, (HLM 1.48)]. FS Date: 10/6/2020

Overview of levee crown, looking US

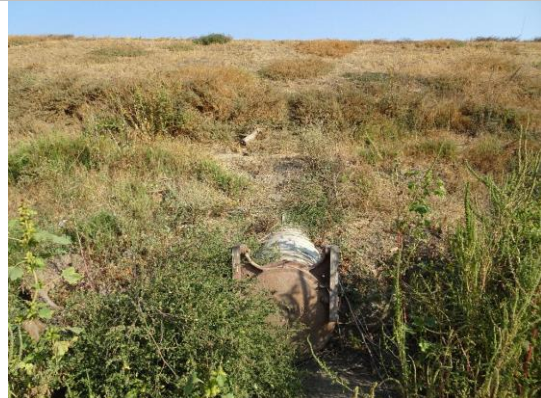
Photo 2 of 3 : UCIP_FA_2022_70643_90570.jpg

Pipe and flapgate visible on WS toe

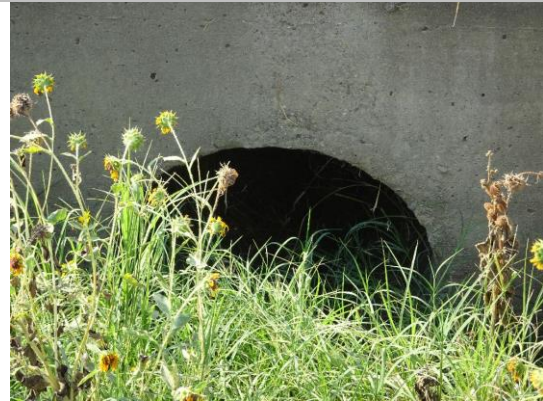
Photo 3 of 3 : UCIP_FA_2022_70643_90566.jpg

Pipe partially visible on LS toe

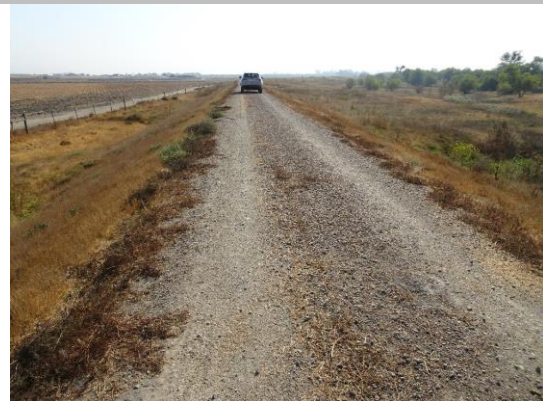
Photo 1 of 3 : UCIP_FA_2022_70644_90572.jpg

DS_ID:19589
FS_ID:70644
EP_NO: N/A
Repair Type: Non-Urgent
EVAL Issue: 5, Pipe Damage
Crossing Status: Found
UCIP Comments: 10/06/2020 Record remains Non-Urgent. DWR DMP has found integrity issues, LOF between 4 and 5. Crossing will be monitored until funding becomes available for rehabilitation. No permit was found authorizing this encroachment. CVFPB will need to review crossing to determine owner. Dense vegetation was found along the WS and LS toe. Recommend removing vegetation along the pipe alignment. Based on the 2014 photos, the LS toe appears to be heavily silted up. Recommend removing silt to increase flow capacity and meet pipe design capacity. (B. Singh - GEI, O. Magana - DWR UCIP)04/08/2014 Heavy sediment buildup in pipe at LS toe. (DWR UCIP - W. Wylie)
FIELD_STRUCT_DESC: 24-inch corrugated metal (CM) gravity drainage pipe through the levee, 13.6 feet below the crown. Flap gate on the waterside (WS) end. Brass cap No. 108 bench mark (BM) on the headwall on the landside (LS). [Additional Reference(s): DWR Levee Log, 2002, (HLM 1.70). USACE San Joaquin O&M Manual, Unit No. 601, Part No. 1, (SJR601.1), 1967, Revised 25 May 2011, (HLM 1.69)].

Overview of levee crown, looking US

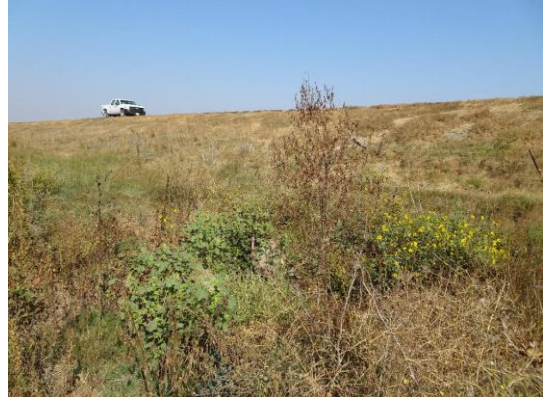
Photo 2 of 3 : UCIP_FA_2022_70644_90575.jpg

WS view: Flapgate and headwall visible at WS toe; dense vegetation

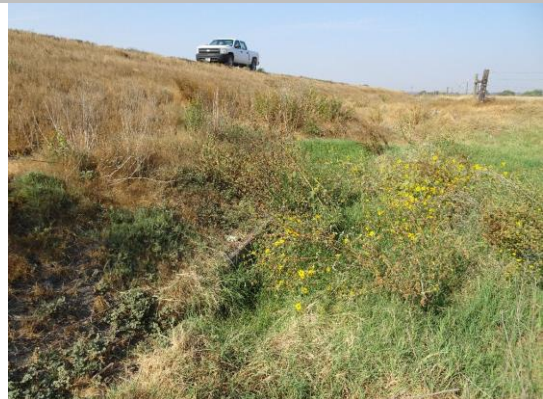
Photo 3 of 3 : UCIP_FA_2022_70644_90576.jpg

LS view: Headwall and pipe partially visible at LS toe; dense vegetation

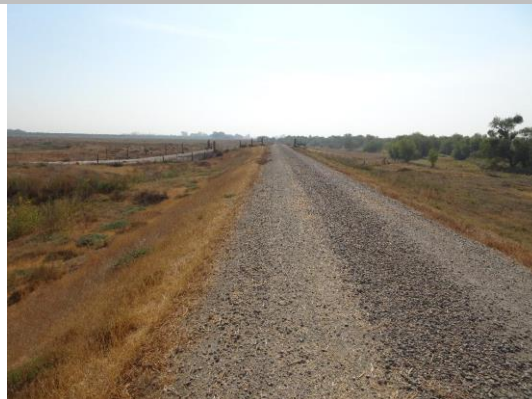
Photo 1 of 3 : UCIP_FA_2022_70645_90581.jpg

DS_ID:19590
FS_ID:70645
EP_NO: N/A
Repair Type: Non-Urgent
EVAL Issue:
Crossing Status: Found
UCIP Comments: 10/06/2020 Record has been updated from No Action Needed to Non-Urgent. No permit was found authorizing this encroachment. CVFPB will need to review crossing to determine owner. DWR DMP internal inspection is pending and scheduled for 2021. Dense vegetation was observed along the pipe alignment and both WS and LS toe. Recommend clearing vegetation along pipe alignment. (B. Singh - GEI, O. Magana - DWR UCIP)
FIELD_STRUCT_DESC: 36-inch corrugated metal (CM) gravity drainage pipe through the levee, 14.2 feet below the crown. Flap gate on the waterside (WS) end. Brass cap No. 100 bench mark (BM) on the headwall on the landside (LS). [Additional Reference(s): DWR Levee Log, 2002, (HLM 1.84). USACE San Joaquin O&M Manual, Unit No. 601, Part No. 1, (SJR601.1), 1967, Revised 25 May 2011, (HLM 1.83)].

Overview of levee crown, looking upstream

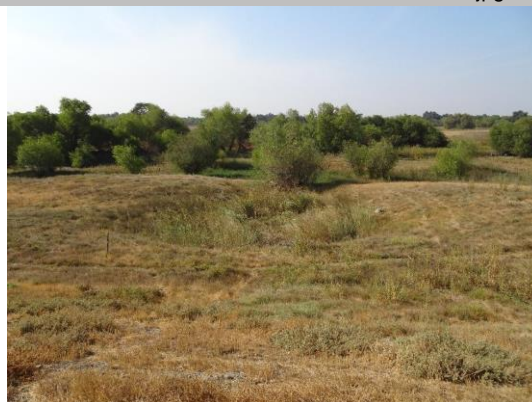
Photo 2 of 3 : UCIP_FA_2022_70645_90582.jpg

WS view: Pipe, flapgate, and headwall are not visible at WS toe from levee crown

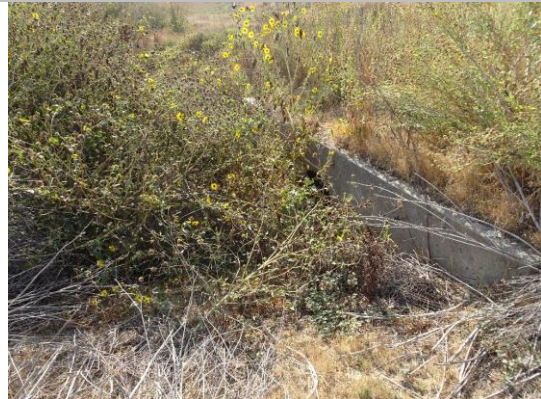
Photo 3 of 3 : UCIP_FA_2022_70645_90578.jpg

LS view: Pipe and concrete headwall partially visible at LS toe

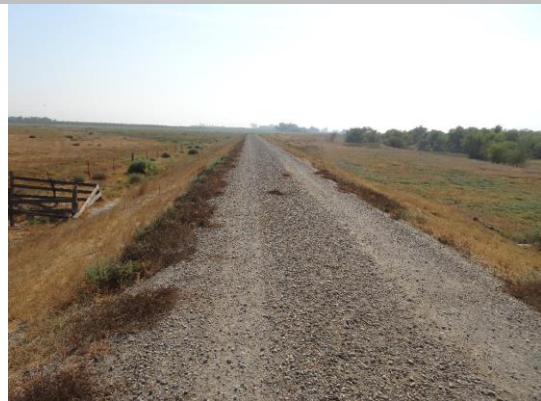
Photo 1 of 3 : UCIP_FA_2022_70646_90611.jpg

DS_ID:19591
 FS_ID:70646
 EP_NO: N/A
 Repair Type: Non-Urgent
 EVAL Issue:
 Crossing Status: Found
 UCIP Comments: 10/06/2020 Record remains Non-Urgent. Rodent activity found in the general area. No permit was found authorizing this encroachment. CVFPB will need to review crossing to determine owner. DWR DMP has not found internal issues, LOF between 1 and 2. Recommend inspection in 5 years. (B. Singh - GEI, O. Magana - DWR UCIP)04/08/2014 Need to contact owner to determine crossing status. Inlet drop box silted in and needs to be cleaned out. (W. Wylie - DWR UCIP)
 FIELD_STRUCT_DESC: 24-inch corrugated metal (CM) gravity drainage pipe through the levee, 9.7 feet below the crown. Flap gate on the waterside (WS) end. Brass cap No. 100 bench mark (BM) on the headwall on the landside (LS). Wooden barrier around drop inlet on the LS toe. [Additional Reference(s): DWR Levee Log, 2002, (HLM 1.98). USACE San Joaquin O&M Manual, Unit No. 601, Part No. 1, (SJR601.1), 1967, Revised 25 May 2011, (HLM 1.98)].

Overview of levee crown, looking US

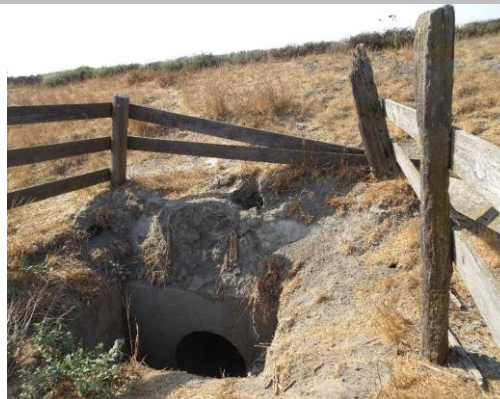
Photo 2 of 3 : UCIP_FA_2022_70646_90615.jpg

LS view: Pipe and headwall at LS toe

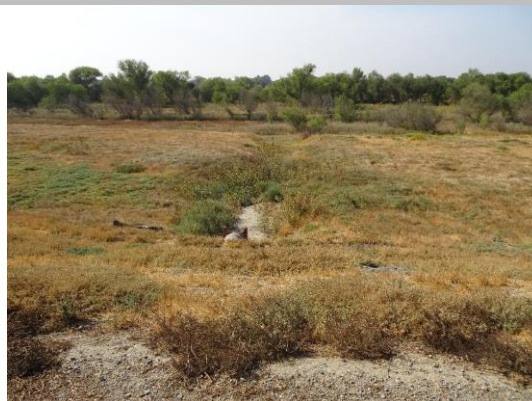
Photo 3 of 3 : UCIP_FA_2022_70646_90612.jpg

WS view: Pipe and flapgate visible on WS toe

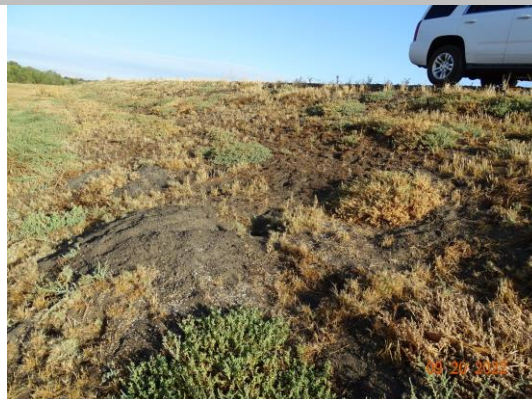
Photo 1 of 1 : FA_2022_NA0010_118_122_20221007_00292.jpg

LM Start	1.97	Rating **	M	Issue No.	122
LM End	1.97	Issue Type +	Ma	Location *	WS
Category	Earthen Levee			GPS Latitude/Longitude	
				Start	End
Item	Animal Control			37.334259 °	37.334259 °
				-120.940113 °	-120.940113 °
DWR ID	DWR_NA0010_01_f_2022_122				
Comment Code					
A3 : No rodents visible, but rodent burrows visible; need to backfill and compact or grout burrows.					
Inspector Comment

View of large rodent burrow on the waterside slope. (Fall 2022)

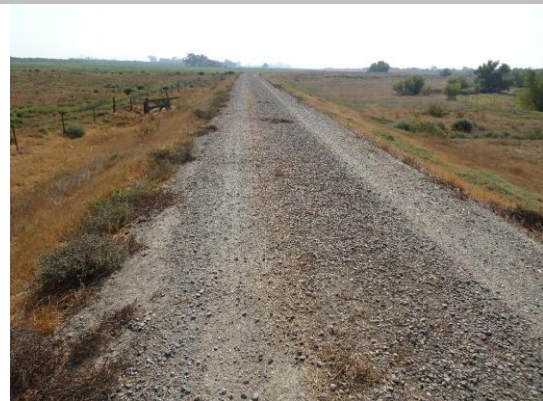
Photo 1 of 3 : UCIP_FA_2022_70647_90617.jpg

Comment Code						
Inspector Comment						
DS_ID:19570 FS_ID:70647 EP_NO: N/A Repair Type: Urgent EVAL Issue: 1, Pipe Integrity Crossing Status: Found UCIP Comments: 10/06/2020 Record updated from Non-Urgent to Urgent. DMP internal video inspection has found pipe integrity issues. LOF of crossing is between 5 and 6. Crossing will be monitored until funding becomes available to address the issues. Wooden barrier surrounding drop-inlet is dilapidated. No permit was found authorizing this encroachment. CVFPB will need to review crossing to determine owner. (B. Singh - GEI, O. Magana - DWR UCIP) 04/08/2014 Unable to find inlet on landward toe. Recommend clearing vegetation on landward side to properly inspect inlet. (W. Wylie - DWR UCIP) FIELD_STRUCT_DESC: 24-inch corrugated metal (CM) gravity drainage pipe through the levee, 9.8 feet below the crown. Flap gate on the waterside (WS) end. Brass cap No. 100 bench mark (BM) on the headwall on the landside (LS). [Additional Reference(s): DWR Levee Log, 2002, (HLM 2.08). USACE San Joaquin O&M Manual, Unit No. 601, Part No. 1, (SJR601.1), 1967, Revised 25 May 2011, (HLM 2.08)]. FS Date: 10/6/2020

Overview of levee crown, looking US

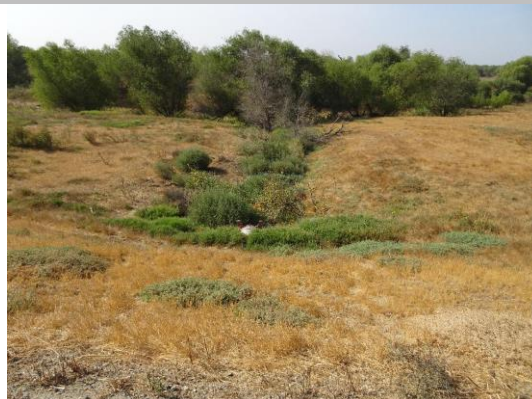
Photo 2 of 3 : UCIP_FA_2022_70647_90618.jpg

WS view: Pipe and flapgate visible on WS toe

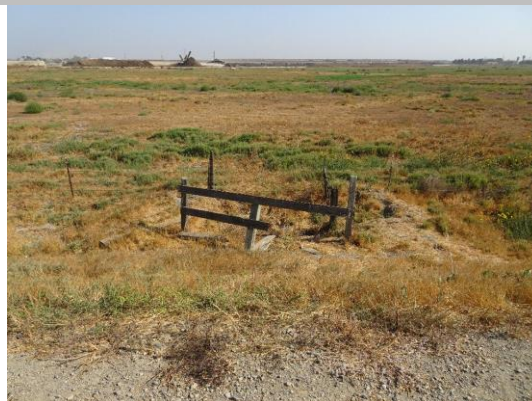
Photo 3 of 3 : UCIP_FA_2022_70647_90619.jpg

LS view: Wooden barrier around drop-inlet on LS toe is dilapidated

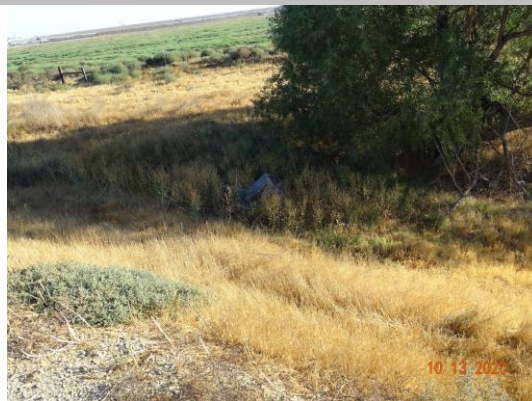
Photo 1 of 1 : FA_2022_NA0010_118_110_20220822_00012.jpg

LM Start	2.20	Rating **	N	Issue No.	110
LM End	2.20	Issue Type +	Ma	Location *	LS
Category	Earthen Levee			GPS Latitude/Longitude	
				Start	End
Item	Trim / Thin Trees			37.331820 °	37.331820 °
				-120.937605 °	-120.937605 °
DWR ID	DWR_NA0010_01_f_2018_110				
Comment Code					
T5 : Tree stumps.					
Inspector Comment					
Tree stump on landside slope should be removed.

View of tree stump on the landside slope. (Fall 2020)

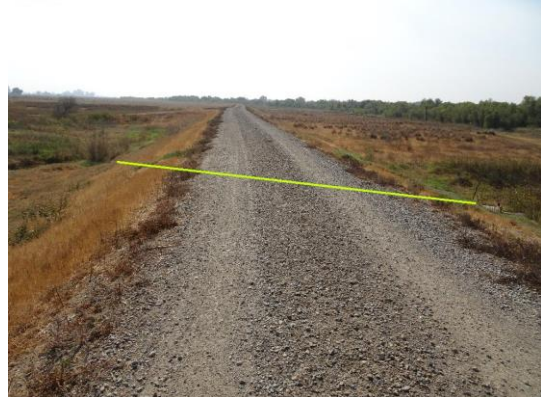
Photo 1 of 3 : UCIP_FA_2022_70648_90625.jpg

Comment Code						
Inspector Comment						
DS_ID:19571 FS_ID:70648 EP_NO: N/A Repair Type: Non-Urgent EVAL Issue: Crossing Status: Found UCIP Comments: 10/06/2020 Record has been updated from No Action Needed to Non-Urget. Pipe angle through the levee. System description has been updated. No permit was found authorizing this encroachment. CVFPB will need to review crossing to determine owner. DWR DMP internal inspection is pending and scheduled for 2021. (B. Singh - GEI, O. Magana - DWR UCIP) FIELD_STRUCT_DESC: 36-inch corrugated metal (CM) gravity drainage pipe through the levee at an angle, 12.6 feet below the crown. Flap gate on the waterside (WS) end. Brass cap No. 100 bench mark (BM) on the headwall on the landside (LS). Wooden barrier around drop inlet on the LS toe. [Additional Reference(s): DWR Levee Log, 2002, (HLM 2.25). USACE San Joaquin O&M Manual, Unit No. 601, Part No. 1, (SJR601.1), 1967, Revised 25 May 2011, (HLM 2.25)]. FS Date: 10/6/2020

Overview of levee crown, looking US. Pipe angled through levee at alignment shown

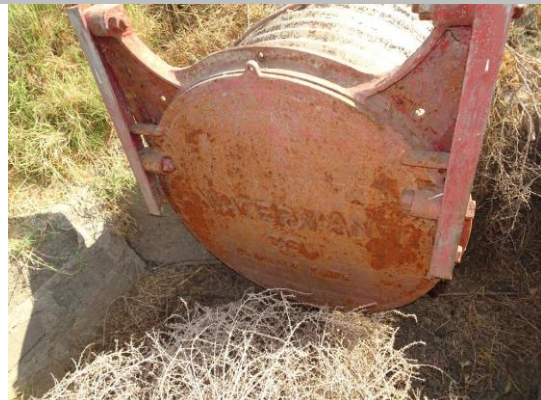
Photo 2 of 3 : UCIP_FA_2022_70648_90628.jpg

WS view: Pipe, flapgate, and headwall on WS toe

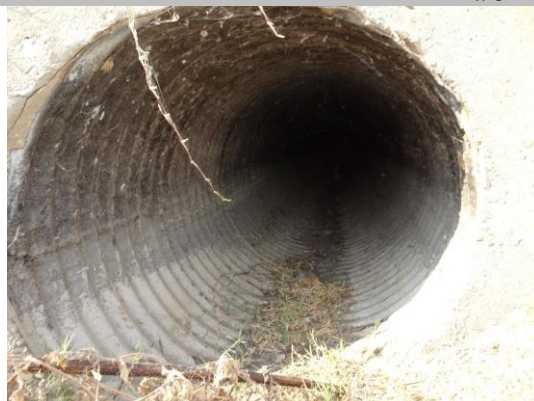
Photo 3 of 3 : UCIP_FA_2022_70648_90623.jpg

LS view: inside view of pipe

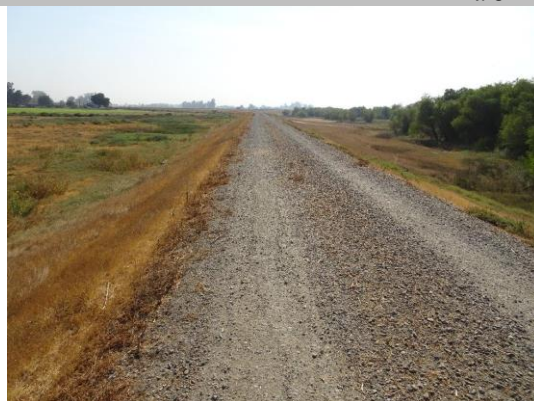
Photo 1 of 3 : UCIP_FA_2022_70649_90632.jpg

DS_ID:19572
 FS_ID:70649
 EP_NO: N/A
 Repair Type: Non-Urgent
 EVAL Issue:
 Crossing Status: Found
 UCIP Comments: 10/06/2020 Record has been updated from No Action Needed to Non-Urgent. No permit was found authorizing this encroachment. CVFPB will need to review crossing to determine owner. DWR DMP has not found internal issues, LOF between 1 and 2. Recommend inspection in 5 years. (B. Singh - GEI, O. Magana - DWR UCIP)
 FIELD_STRUCT_DESC: 24-inch corrugated metal (CM) gravity drainage pipe through the levee, 8.0 feet below the crown. Flap gate on the waterside (WS) end. Brass cap No. 100 bench mark (BM) on the headwall on the landside (LS). [Additional Reference(s): DWR Levee Log, 2002, (HLM 2.53). USACE San Joaquin O&M Manual, Unit No. 601, Part No. 1, (SJR601.1), 1967, Revised 25 May 2011, (HLM 2.52)].
 FS Date: 10/6/2020

Overview of levee crown, looking US

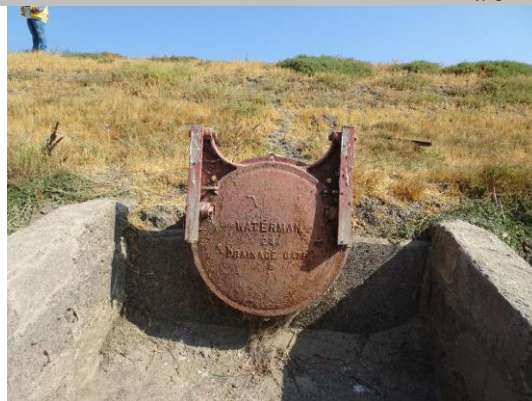
Photo 2 of 3 : UCIP_FA_2022_70649_90635.jpg

WS view: Pipe, flapgate, and headwall on WS toe

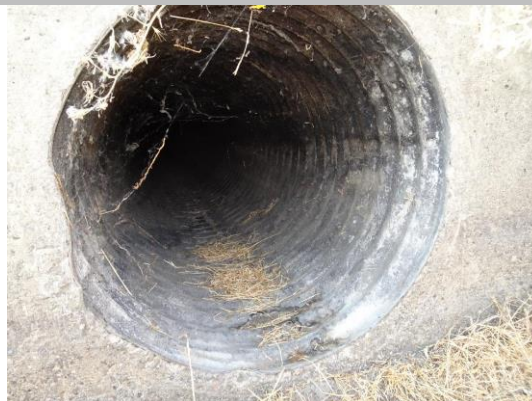
Photo 3 of 3 : UCIP_FA_2022_70649_90636.jpg

LS view: close up view inside pipe inlet

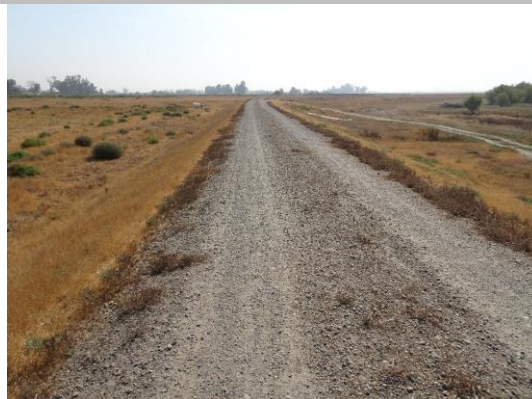
Photo 1 of 3 : UCIP_FA_2022_70650_90637.jpg

DS_ID:19573
FS_ID:70650
EP_NO: N/A
Repair Type: Non-Urgent
EVAL Issue:
Crossing Status: Found
UCIP Comments: 10/06/2020 Record remains Non-Urgent. No permit was found authorizing this encroachment. CVFPB will need to review crossing to determine owner. DWR DMP has not found internal issues, LOF between 1 and 2. Recommend inspection in 5 years. (B. Singh - GEI, O. Magana - DWR UCIP)04/08/2014 Sedimentation in pipe at landward toe. (W. Wylie - DWR UCIP)
FIELD_STRUCT_DESC: 24-inch corrugated metal (CM) gravity drainage pipe through the levee, 7.3 feet below the crown. Flap gate on the waterside (WS) end. Brass cap No. 100 bench mark (BM) on the headwall on the landside (LS). [Additional Reference(s): DWR Levee Log, 2002, (HLM 2.71). USACE San Joaquin O&M Manual, Unit No. 601, Part No. 1, (SJR601.1), 1967, Revised 25 May 2011, (HLM 2.70)].
FS Date: 10/6/2020

Overview of levee crown, looking US

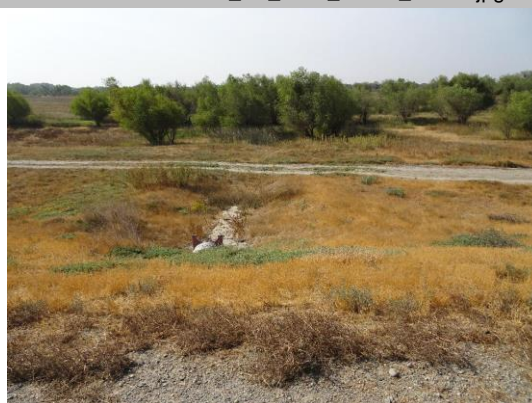
Photo 2 of 3 : UCIP_FA_2022_70650_90638.jpg

WS view: Pipe and flapgate visible on WS toe

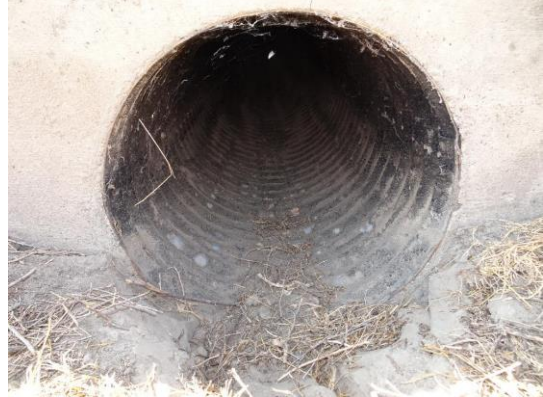
Photo 3 of 3 : UCIP_FA_2022_70650_90642.jpg

WS view: Pipe and headwall at WS toe

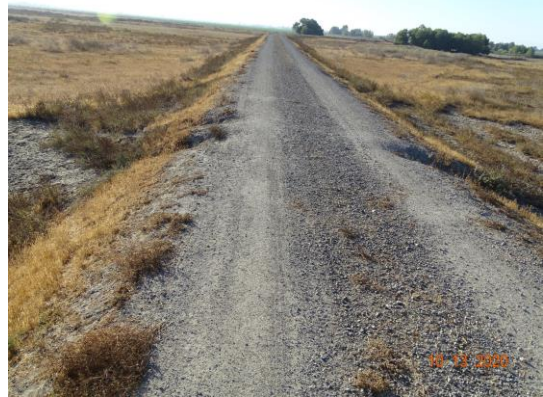
Photo 1 of 1 : FA_2022_NA0010_118_114_20220822_00015.jpg

LM Start	2.99	Rating **	U	Issue No.	114
LM End	2.99	Issue Type +	Ma	Location *	LS
Category	Earthen Levee			GPS Latitude/Longitude	
				Start	End
Item	Erosion / Livestock			37.323328 °	37.323328 °
				-120.929521 °	-120.929521 °
DWR ID	DWR_NA0010_01_f_2018_114				
Comment Code					
E4 : Repair the levee slope damaged by livestock and prevent large animal access.					
Inspector Comment					
Slope damage caused by livestock on both landside and waterside slope has eroded into the levee crown.

View of damage to both slopes from livestock activity. (Fall 2020)

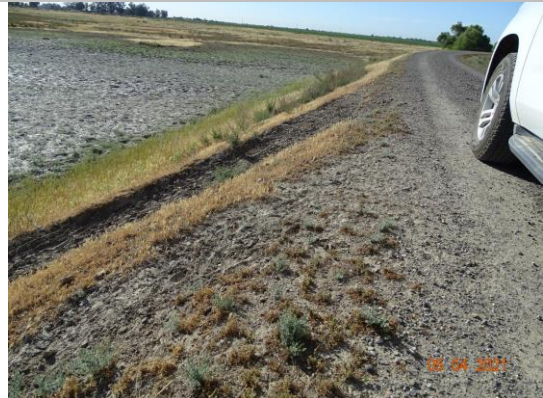
Photo 1 of 1 : FA_2022_NA0010_118_104_20220822_00008.jpg

LM Start	3.06	Rating **	M	Issue No.	104
LM End	3.06	Issue Type +	Ma	Location *	LS
Category	Earthen Levee			GPS Latitude/Longitude	
				Start	End
Item	Erosion / Livestock			37.322499 °	37.322499 °
				-120.928986 °	-120.928986 °
DWR ID	DWR_NA0010_01_f_2017_104				
Comment Code					
E4 : Repair the levee slope damaged by livestock and prevent large animal access.					
Inspector Comment					
Slope damage caused by animal foot traffic.

Slope damage on the landside slope from livestock traffic. (Spring 2021)

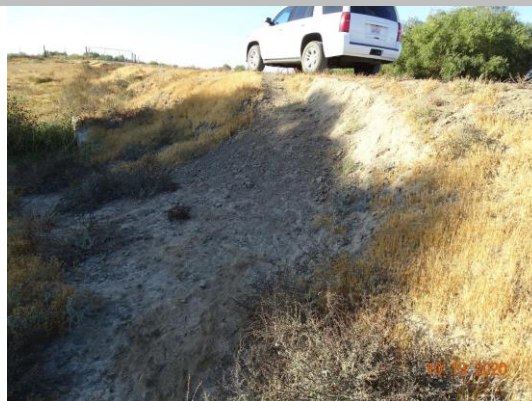
Photo 1 of 1 : FA_2022_NA0010_118_108_20220822_00011.jpg

LM Start	3.13	Rating **	M	Issue No.	108
LM End	3.13	Issue Type +	Ma	Location *	LS
Category	Earthen Levee			GPS Latitude/Longitude	
				Start	End
Item	Erosion / Livestock			37.321488 °	37.321488 °
				-120.928758 °	-120.928758 °
DWR ID	DWR_NA0010_01_s_2017_108				
Comment Code					
E4 : Repair the levee slope damaged by livestock and prevent large animal access.					
Inspector Comment					
Slope damage caused by animal traffic on landside toe.

View of landside slope damage by animal traffic. (Fall 2020)

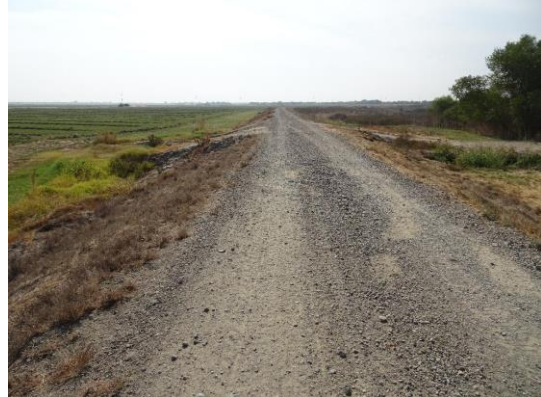
Photo 1 of 3 : UCIP_FA_2022_70652_90588.jpg

Comment Code					
Inspector Comment					
DS_ID:19575 FS_ID:70652 EP_NO: N/A Repair Type: Urgent EVAL Issue: 1, Pipe Integrity Crossing Status: Found UCIP Comments: 10/06/2020 Record remains Urgent. Sinkhole present directly above the LS headwall and along pipe alignment. Pipe collapse visible from from the LS toe. Erosion present on the WS just behind the flap gate. No permit was found authorizing this encroachment. CVFPB will need to review crossing to determine owner. DWR DMP internal inspection is pending and scheduled in 2021. (B. Singh - GEI, O. Magana - DWR UCIP)11/01/2018 Pipe continues to rust through, causing the pipe to collapse on the LS. Sediment buildup visible from the LS inlet. Loss of soil just above the LS concrete headwall and along the LS slope. Crossing remains Urgent due to the levee slope issues and pipe failure through the levee. (O. Magana - DWR UCIP)07/19/2016 Same as previous inspection. Erosion present on LS slope. (O. Magana - DWR UCIP)04/08/2014 Pipe rusted through at Springline on LS toe. Flapgate blocked by sediment on WS toe. Heavy sediment on both ends of pipe. Need to contact owner to address issues. (W. Wylie - DWR UCIP) FIELD_STRUCT_DESC: 36-inch corrugated metal (CM) gravity drainage pipe through the levee, 9.7 feet below the crown. Flap gate on the waterside (WS) end. Brass cap No. 100 bench mark (BM) on the headwall on the landside (LS). [Additional Reference(s): DWR Levee Log, 2002, (HLM 3.50). USACE San Joaquin O&M Manual, Unit No. 601, Part No. 1, (SJR601.1), 1967, Revised 25 May 2011, (HLM 3.50)]. FS Date: 10/6/2020

Overview of levee crown, looking US

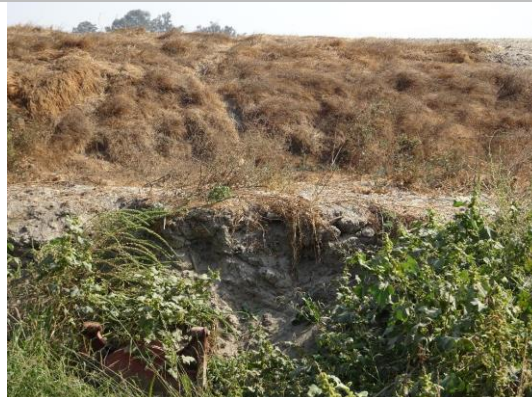
Photo 2 of 3 : UCIP_FA_2022_70652_90586.jpg

WS view: Slope from WS toe

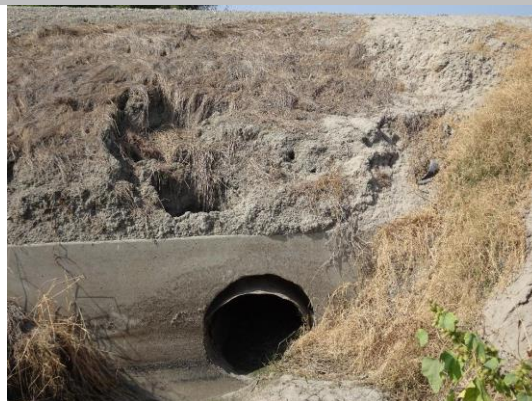
Photo 3 of 3 : UCIP_FA_2022_70652_90591.jpg

LS view: Pipe, headwall, and sinkhole at LS toe

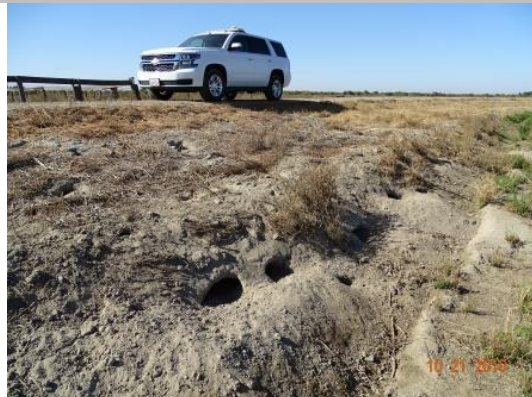
Photo 1 of 1 : FA_2022_NA0010_118_2_20220822_00001.jpg

LM Start	3.87	Rating **	U	Issue No.	2
LM End	3.90	Issue Type +	Ma	Location *	LS
Category	Earthen Levee			GPS Latitude/Longitude	
				Start	End
Item	Animal Control			37.311798 °	37.311341 °
				-120.927670 °	-120.927365 °
DWR ID	DWR_NA0010_01_s_2012_2				
Comment Code					
A1 : Exterminate rodents and backfill and compact or grout burrows.					
Inspector Comment					
Several rodent burrows are along this section of the levee.

View of rodent burrows in this section looking downstream. (Fall 2019)

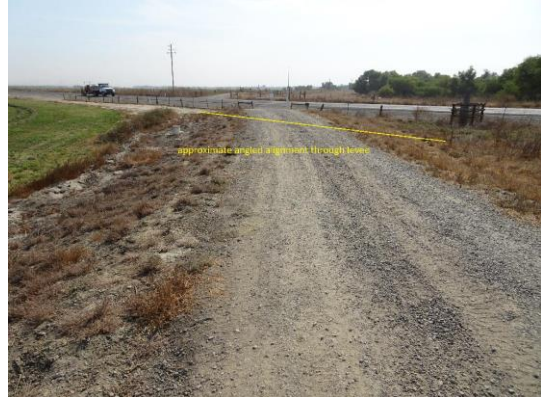
Photo 1 of 3 : UCIP_FA_2022_70653_90650.jpg

Comment Code					
Inspector Comment					
DS_ID:19576 FS_ID:70653 EP_NO: N/A Repair Type: Urgent EVAL Issue: 3a, Flood Risk Crossing Status: Found UCIP Comments: 10/06/2020 Record updated from Non-Urgent to Urgent. Heavy siltation through the length of the pipe was observed and recommend removal. Flap gate is missing on the WS toe. Recommend adding flap gate to prevent flooding from the WS to the LS. No permit was found authorizing this encroachment. CVFPB will need to review crossing to determine owner. DWR DMP internal inspection is pending and scheduled for 2021. Pipe goes through the levee at an angle. System description has been updated to include angled pipe information.(B. Singh - GEI, O. Magana - DWR UCIP)04/08/2014 Slide gate missing from WS. No closure device, but degrading of levee at Highway 140 is lower than pipe, so this does not appear to be a critical issue. Also dense vegetation limits the inspector's visibility to identify signs of pipe failure (leaks) along the slope. Recommend removing vegetation along pipe alignment to conduct proper inspection of structure and appurtenances. (W. Wylie - DWR UCIP) FIELD_STRUCT_DESC: 30-inch corrugated metal (CM) gravity drainage pipe through the levee at an angle, 3.5 feet below the crown. Flap gate on the waterside (WS) end. Brass cap No. 100 bench mark (BM) on the headwall on the landside (LS). [Additional Reference(s): DWR Levee Log, 2002, (HLM 3.95). USACE San Joaquin O&M Manual, Unit No. 601, Part No. 1, (SJR601.1), 1967, Revised 25 May 2011, (HLM 3.95)]. FS Date: 10/6/2020

Overview of levee crown, looking US. Angled pipe alignment through levee crown approximated.

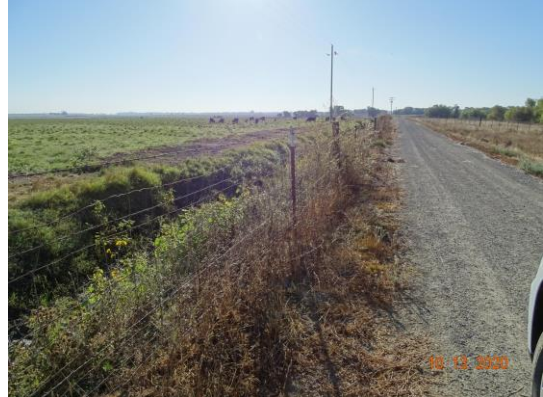
Photo 1 of 1 : FA_2022_NA0010_118_118_20220822_00019.jpg

LM Start	3.99	Rating **	M	Issue No.	118
LM End	4.25	Issue Type +	En	Location *	LS
Category	Earthen Levee			GPS Latitude/Longitude	
				Start	End
Item	Encroachments			37.310693 °	37.307895 °
				-120.926024 °	-120.922935 °
DWR ID	DWR_NA0010_01_f _ 2018_118				
Comment Code					
FE : Fence					
Inspector Comment					
Fence along landside toe.

View of fence on the landside shoulder and toe. (Fall 2020)

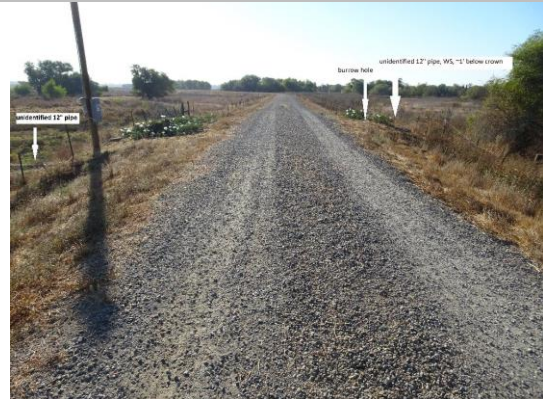
Photo 1 of 3 : UCIP_FA_2022_70655_90661.jpg

Comment Code						
Inspector Comment						
DS_ID:19607 FS_ID:70655 EP_NO: N/A Repair Type: Non-Urgent EVAL Issue: 10, Unauthorized Modification or Non-Compliant Permit Crossing Status: Found UCIP Comments: 10/20/2020 Record remains Non-Urgent. Barbed wire prevented access to the pipe located on the LS toe. Unpermitted modifications were made to the structure. There appears to be multiple crossings at this location, two 12-inch pipes and 48-inch refurbished pipe. Recommend adding new DSID for the second 12-inch pipe found during field inspection. Portion of concrete headwall visible on the WS toe that corresponds to 48-inch pipe. Recommend contacting owner to determine status of structure and obtain as-builts. No permit was found authorizing these encroachments. CVFPB will need to review crossing to determine owner(s). (B. Singh - GEI, O. Magana - DWR UCIP)04/08/2014 Pipe appears sleeved with a 12-inch steel pipe with a slide gate at the LS toe. No identified authorization for changes to this crossing. Need to contact owner to obtain additional information about the modifications to crossing. (W. Wylie - DWR UCIP) FIELD_STRUCT_DESC: 48-inch corrugated metal (CM) gravity drainage pipe through the levee, 14.0 feet below the crown. Flap gate on the waterside (WS) end. Brass cap No. 90 bench mark (BM) on the headwall on the landside (LS). [Additional Reference(s): DWR Levee Log, 2002, (HLM 4.16). USACE San Joaquin O&M Manual, Unit No. 601, Part No. 1, (SJR601.1), 1967, Revised 25 May 2011, (HLM 4.16)]. FS Date: 10/20/2020

Overview of levee crown showing location of burrow hole and alignment of unauthorized 12" pipe

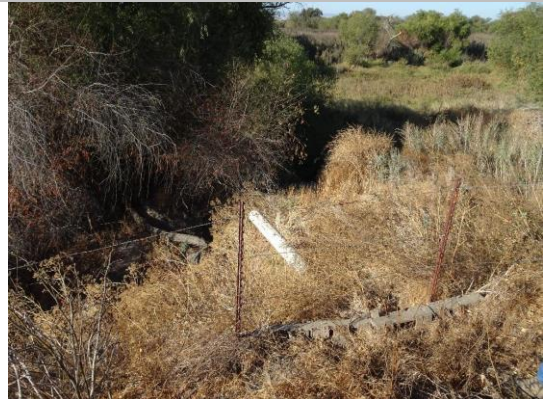
Photo 2 of 3 : UCIP_FA_2022_70655_90662.jpg

WS view: Unauthorized 12-inch PVC pipe on WS, approximately 1 foot below levee crown.

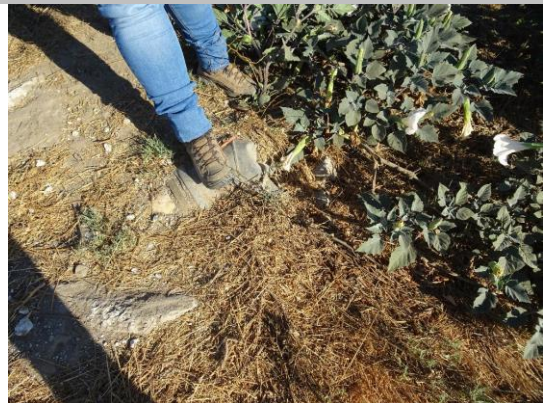
Photo 3 of 3 : UCIP_FA_2022_70655_90665.jpg

LS view: Abandoned pipe through levee crown

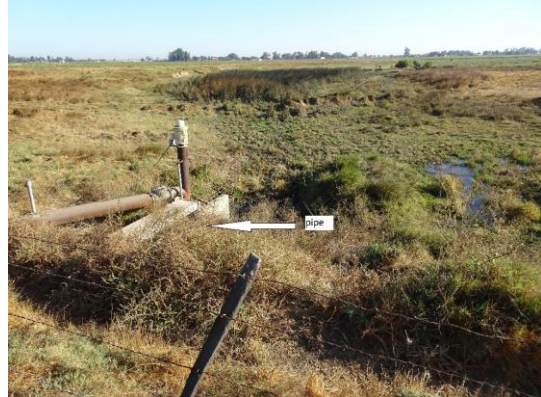
Photo 1 of 1 : UCIP_FA_2022_70656_90667.jpg

Comment Code					
Inspector Comment					
DS_ID:24866 FS_ID:70656 EP_NO: N/A Repair Type: Non-Urgent EVAL Issue: 10, Unauthorized Modification or Non-Compliant Permit Crossing Status: Found UCIP Comments: 10/20/2020 Record remains Non-Urgent. Barbed wire prevented access to the pipe located on the LS toe. Unpermitted modifications were made to the structure. There appears to be multiple crossings at this location, two 12-inch pipes and 48-inch refurbished pipe. Recommend contacting owner to determine status of structure and obtain as-builts. No permit was found authorizing these encroachments. CVFPB will need to review crossing to determine owner(s). (B. Singh - GEI, O. Magana - DWR UCIP)04/08/2014 Need to contact owner to get details of crossing. (W. Wylie - DWR UCIP) FIELD_STRUCT_DESC: 12-inch steel drainage discharge pipe through the levee, 2.5 feet below the crown. 12-inch steel pipe, vent, and pump on stand visible on the landside (LS) slope. 10-inch polyvinyl chloride (PVC) pipe visible on the waterside (WS) slope. FS Date: 10/20/2020

LS view: Location of pipe. Inspection inhibited by barbed wire fencing and dense vegetation

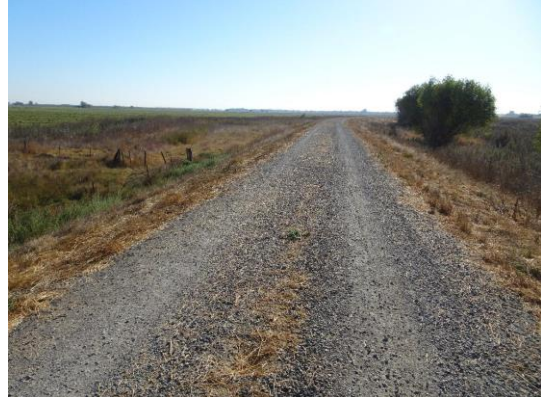
Photo 1 of 3 : UCIP_FA_2022_70657_90668.jpg

DS_ID:19608
FS_ID:70657
EP_NO: N/A
Repair Type: Non-Urgent
EVAL Issue:
Crossing Status: Found
UCIP Comments: 10/20/2020 Record remains Non-Urgent. Fence and dense vegetation prevented full inspection along the WS and LS slopes. Burrowing observed on LS and WS slopes. No permit was found authorizing this encroachment. CVFPB will need to review crossing to determine owner. DWR DMP internal inspection is pending and scheduled for 2021. (B. Singh - GEI, O. Magana - DWR UCIP)04/08/2014 Dense vegetation and fence limits the inspector's visibility to identify signs of pipe failure (leaks) along the landward side. Recommend obtaining access to landward toe and removing vegetation along pipe alignment to conduct proper inspection of structure and appurtenances. (W. Wylie - DWR UCIP)
FIELD_STRUCT_DESC: 24-inch corrugated metal (CM) gravity drainage pipe through the levee, 11.9 feet below the crown. Flap gate on the waterside (WS) end. Brass cap No. 90 bench mark (BM) on the headwall on the landside (LS). [Additional Reference(s): DWR Levee Log, 2002, (HLM 4.27). USACE San Joaquin O&M Manual, Unit No. 601, Part No. 1, (SJR601.1), 1967, Revised 25 May 2011, (HLM 4.27)].

Overview of levee crown, looking US
