Flood Control Project Maintenance Levee Inspections

Fall 2022 Levee Maintenance Deficiency Summary Report

San Joaquin River Basin

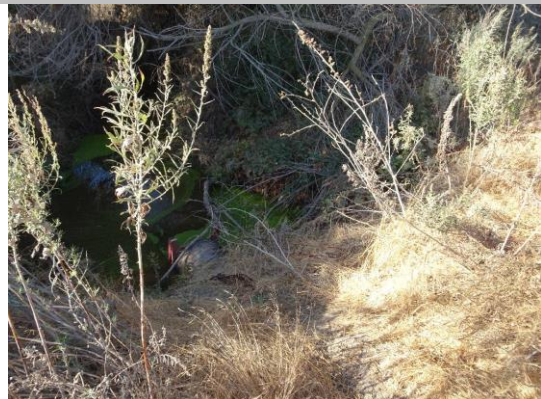
Photo 2 of 3 : UCIP_FA_2022_70657_90672.jpg

WS view: Pipe and flapgate visible at WS toe. Further inspection inhibited by barbed wire fencing

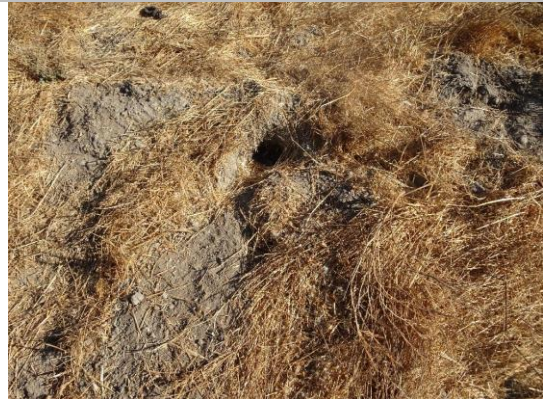
Photo 3 of 3 : UCIP_FA_2022_70657_90673.jpg

Observed burrowing on limited view of LS and WS slopes

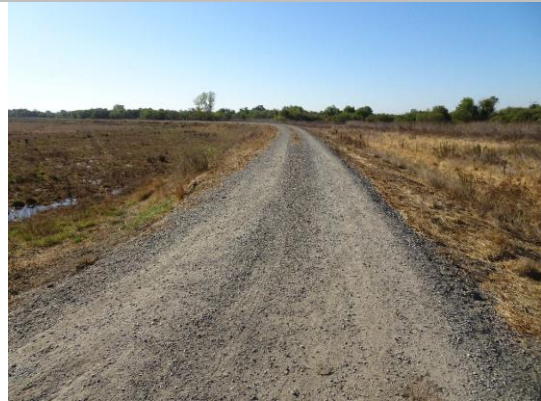
Photo 1 of 3 : UCIP_FA_2022_70658_90676.jpg

Comment Code						
Inspector Comment						
DS_ID:19609 FS_ID:70658 EP_NO: N/A Repair Type: Urgent EVAL Issue: 1, Pipe Integrity Crossing Status: Found UCIP Comments: 10/20/2020 Record has been updated from Non-Urgent to Urgent. DWR DMP has found integrity issues, LOF, between 5 and 6. Crossing will be monitored until funding becomes available to address. Evidence of the landslide visible on the LS slope from the levee crown. No permit was found authorizing this encroachment. CVFPB will need to review crossing to determine owner. (B. Singh - GEI, O. Magana - DWR UCIP)04/08/2014 Dense vegetation limits the inspector's visibility to identify signs of pipe failure (leaks) along the waterward side. Recommend removing vegetation along pipe alignment to conduct proper inspection of structure and appurtenances. (W. Wylie - DWR UCIP) FIELD_STRUCT_DESC: 24-inch corrugated metal (CM) gravity drainage pipe through the levee, 10.0 feet below the crown. Flap gate on the waterside (WS) end. Brass cap No. 90 bench mark (BM) on the headwall on the landside (LS). [Additional Reference(s): DWR Levee Log, 2002, (HLM 4.73). USACE San Joaquin O&M Manual, Unit No. 601, Part No. 1, (SJR601.1), 1967, Revised 25 May 2011, (HLM 4.72)]. FS Date: 10/20/2020

Overview of levee crown, looking US

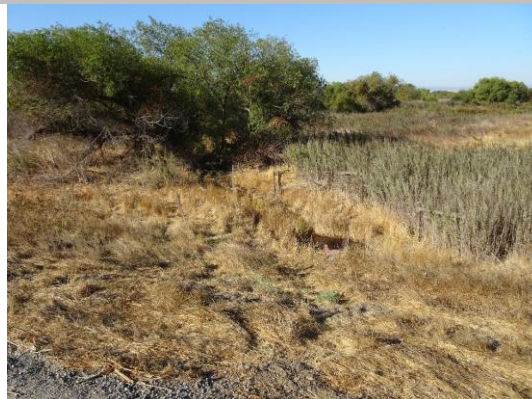
Photo 2 of 3 : UCIP_FA_2022_70658_90678.jpg

WS view: Pipe and flapgate visible at WS toe

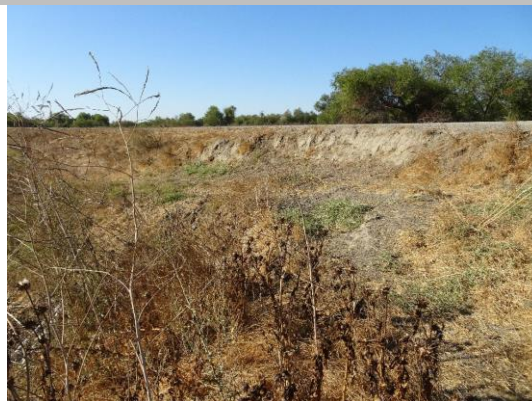
Photo 3 of 3 : UCIP_FA_2022_70658_90681.jpg

LS view: land movement/scarp of LS slope at levee crown

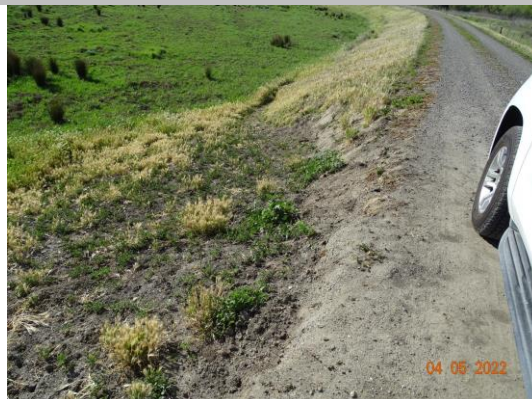
Photo 1 of 1 : FA_2022_NA0010_118_9_20220822_00003.jpg

LM Start	4.69	Rating **	M	Issue No.	9
LM End	4.69	Issue Type +	Ma	Location *	LS
Category	Earthen Levee			GPS Latitude/Longitude	
				Start	End
Item	Erosion / Livestock			37.302398 °	37.302398 °
				-120.920920 °	-120.920920 °
DWR ID	DWR_NA0010_01_s_2013_9				
Comment Code					
E4 : Repair the levee slope damaged by livestock and prevent large animal access.					
Inspector Comment					
Material used to repair the livestock damage in 2021 has eroded away.

View of damage to the landside slope from livestock. (Spring 2022)

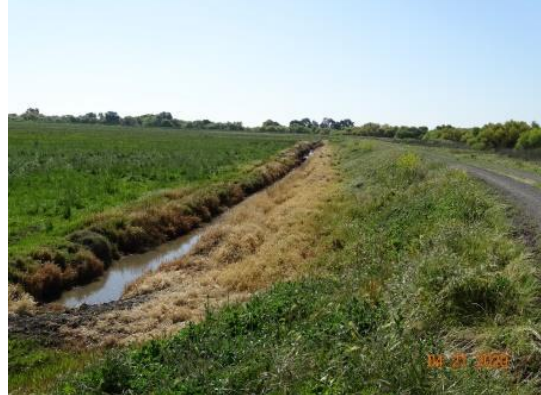
Photo 1 of 1 : FA_2022_NA0010_118_107_20220822_00010.jpg

LM Start	4.77	Rating **	M	Issue No.	107
LM End	5.32	Issue Type +	En	Location *	LS
Category	Earthen Levee			GPS Latitude/Longitude	
				Start	End
Item	Encroachments			37.301269 °	37.300396 °
				-120.920660 °	-120.912625 °
DWR ID	DWR_NA0010_01_s_2019_107				
Comment Code					
DT : Ditch					
Inspector Comment					
Ditch it roughly 8-15 ft away from levee toe.

Looking upstream at an irrigation ditch along the landside toe. (Spring 2020)

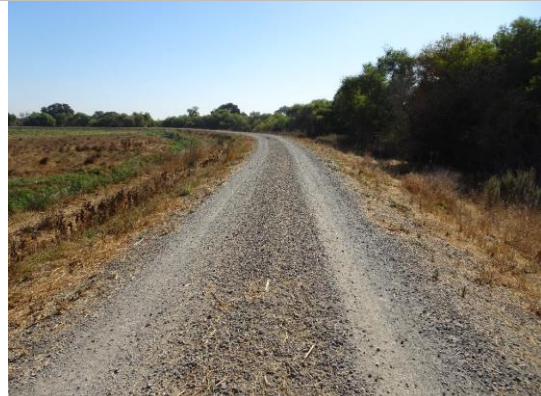
Photo 1 of 3 : UCIP_FA_2022_70659_90682.jpg

Comment Code						
Inspector Comment						
DS_ID:19610 FS_ID:70659 EP_NO: N/A Repair Type: Non-Urgent EVAL Issue: Crossing Status: Found UCIP Comments: 10/20/2020 Record remains Non-Urgent. Unable to locate inlet on the LS toe. Ditch runs along the LS toe. Ditch was running full and no signs of pipe inlet were visible. This pipe appears to be non-functional--only WS pipe outlet found. No permit was found authorizing this encroachment. CVFPB will need to review crossing to determine owner. DWR DMP internal inspection is pending and scheduled for 2021. (B. Singh - GEI, O. Magana - DWR UCIP)04/08/2014 Non-functional -- sediment buildup against flapgate and inlet buried at landward side. (W. Wylie - DWR UCIP) FIELD_STRUCT_DESC: 24-inch corrugated metal (CM) gravity drainage pipe through the levee, 8.0 feet below the crown. Flap gate on the waterside (WS) end. Brass cap No. 90 bench mark (BM) on the headwall on the landside (LS). Drainage ditch along the LS toe. [Additional Reference(s): DWR Levee Log, 2002, (HLM 5.06). USACE San Joaquin O&M Manual, Unit No. 601, Part No. 1, (SJR601.1), 1967, Revised 25 May 2011, (HLM 5.05)]. FS Date: 10/20/2020

Overview of levee crown, looking US

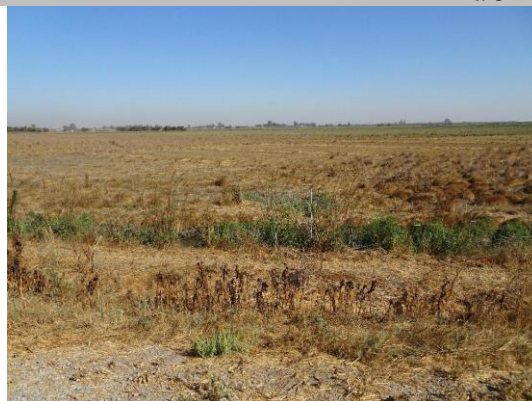
Photo 2 of 3 : UCIP_FA_2022_70659_90683.jpg

LS view: Pipe and headwall not visible at LS toe from levee crown

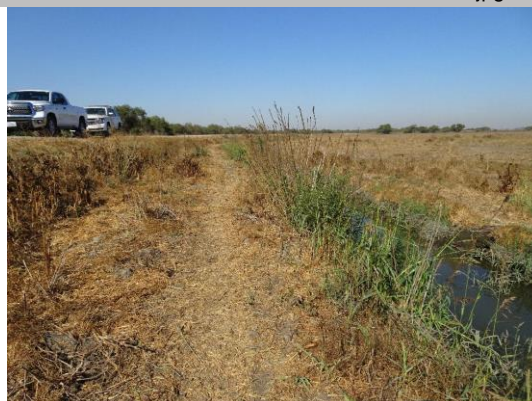
Photo 3 of 3 : UCIP_FA_2022_70659_90685.jpg

LS view: LS pipe and headwall not accessible/visible due to high vegetation

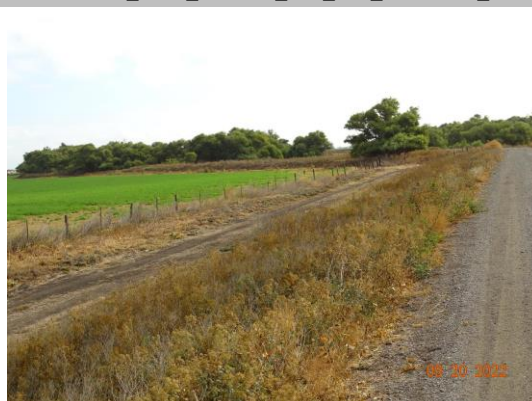
Photo 1 of 1 : FA_2022_NA0010_118_126_20221007_00294.jpg

Looking upstream along the landside slope. (Fall 2022)

LM Start	5.72	Rating **	U	Issue No.	126
LM End	6.13	Issue Type +	Ma	Location *	LS
Category	Earthen Levee			GPS Latitude/Longitude	
				Start	End
Item	Vegetation			37.304094 °	37.304470 °
				-120.907150 °	-120.900095 °
DWR ID	DWR_NA0010_01_f_2022_126				
Comment Code					
V1 : Control annual grass and weeds on the levee slopes and easements.					
Inspector Comment

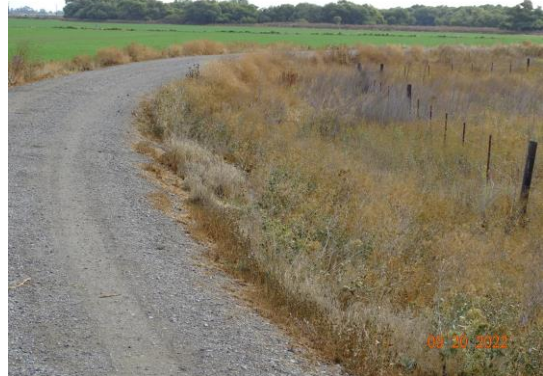
Photo 1 of 1 : FA_2022_NA0010_118_125_20221007_00295.jpg

View of the waterside slope looking upstream. (Fall 2022)

LM Start	5.72	Rating **	U	Issue No.	125
LM End	6.13	Issue Type +	Ma	Location *	WS
Category	Earthen Levee			GPS Latitude/Longitude	
				Start	End
Item	Vegetation			37.304093 °	37.304471 °
				-120.907149 °	-120.900095 °
DWR ID	DWR_NA0010_01_f _ 2022_125				
Comment Code					
V1 : Control annual grass and weeds on the levee slopes and easements.					
Inspector Comment

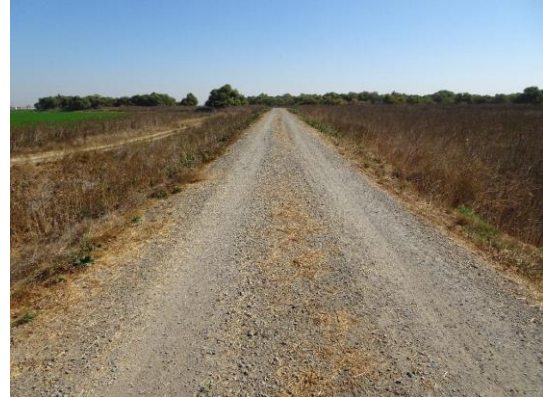
Photo 1 of 3 : UCIP_FA_2022_70660_90689.jpg

Comment Code						
Inspector Comment						
DS_ID:19611 FS_ID:70660 EP_NO: N/A Repair Type: Non-Urgent EVAL Issue: 11, Maintenance Compliance Issue Crossing Status: Found UCIP Comments: 10/20/2020 Record remains Non-Urgent. Depression observed across levee crown, less than 6 inches in depth. Pipe inlet located at the LS toe is completely blocked by soil. This crossing is non-functional. Recommend evaluating the purpose of this drainage structure. No permit was found authorizing this encroachment. CVFPB will need to review crossing to determine owner. DWR DMP internal inspection is pending and scheduled for 2021. Recommend reviewing DMP's internal inspection when completed to investigate reason for depression across the levee crown. (B. Singh - GEI, O. Magana - DWR UCIP)04/08/2014 Dense vegetation limits the inspector's visibility to identify signs of pipe failure (leaks) along waterward and landward slopes. Recommend removing vegetation along pipe alignment to conduct proper inspection of structure and appurtenances. Landward side filled in with soil. Need to contact owner. If crossing is no longer used need to coordinate with CVFPB for proper abandonment. (W. Wylie - DWR UCIP) FIELD_STRUCT_DESC: 24-inch corrugated metal (CM) gravity drainage pipe through the levee, 8.6 feet below the crown. Flap gate on the waterside (WS) end. Brass cap No. 90 bench mark (BM) on the headwall on the landside (LS). [Additional Reference(s): DWR Levee Log, 2002, (HLM 5.96). USACE San Joaquin O&M Manual, Unit No. 601, Part No. 1, (SJR601.1), 1967, Revised 25 May 2011, (HLM 5.95)]. FS Date: 10/20/2020

Overview of levee crown, looking US

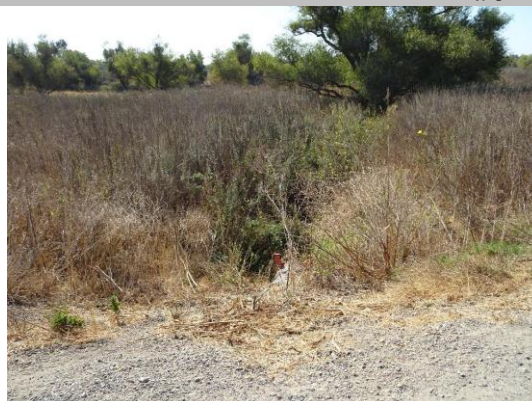
Photo 2 of 3 : UCIP_FA_2022_70660_90691.jpg

WS view: Pipe and flapgate visible at WS toe

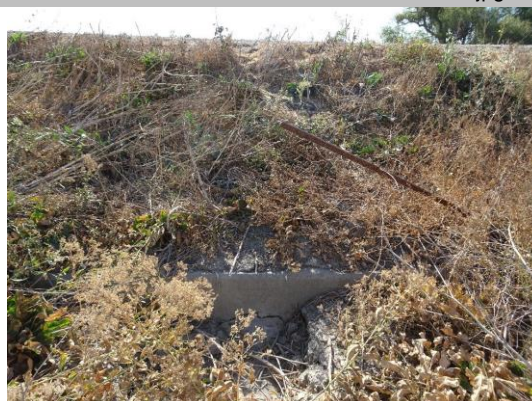
Photo 3 of 3 : UCIP_FA_2022_70660_90692.jpg

LS view: Headwall at LS toe. Pipe is completely blocked by heavy siltation at LS invert.

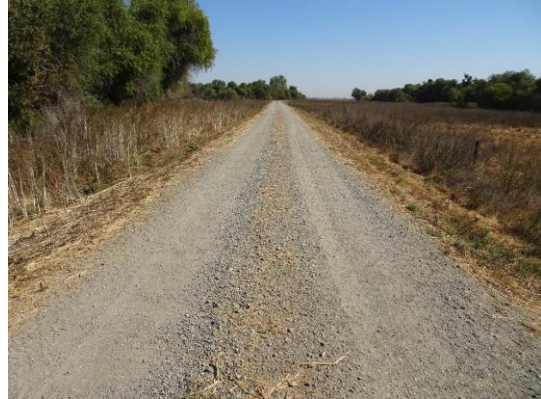
Photo 1 of 3 : UCIP_FA_2022_70661_90696.jpg

Comment Code						
Inspector Comment						
DS_ID:19612 FS_ID:70661 EP_NO: N/A Repair Type: Non-Urgent EVAL Issue: 6, Levee Damage or Threat for Levee Damage Crossing Status: Found UCIP Comments: 10/20/2020 Record remains Non-Urgent. Scour is still present on both sides of the concrete LS headwall. Dense vegetation prevented updates on the scour progression along the LS slope. Recommend re-inspecting pipe when vegetation is removed. Unable to access to WS outlet due to wired fence. No permit was found authorizing this encroachment. CVFPB will need to review crossing to determine owner. DWR DMP internal inspection is pending and scheduled for 2021. (B. Singh - GEI, O. Magana - DWR UCIP)04/08/2014 Dense vegetation limits the inspector's visibility to identify signs of pipe failure (leaks) along waterward and landward slopes. Recommend removing vegetation along pipe alignment to conduct proper inspection of structure and appurtenances. Pipe completely blocked by soil on LS toe due to animal activity. Slide gate blocked open. (W. Wylie - DWR UCIP) FIELD_STRUCT_DESC: 48-inch corrugated metal (CM) gravity drainage pipe through the levee at an angle, 13.1 feet below the crown. Walkway to slide gate at the concrete headwall on the landside (LS) toe. Flap gate at the concrete headwall on the waterside (WS) toe. Brass cap No. 90 bench mark (BM) on the headwall on the LS. [Additional Reference(s): DWR Levee Log, 2002, (HLM 6.13). USACE San Joaquin O&M Manual, Unit No. 601, Part No. 1, (SJR601.1), 1967, Revised 25 May 2011, (HLM 6.13)]. FS Date: 10/20/2020

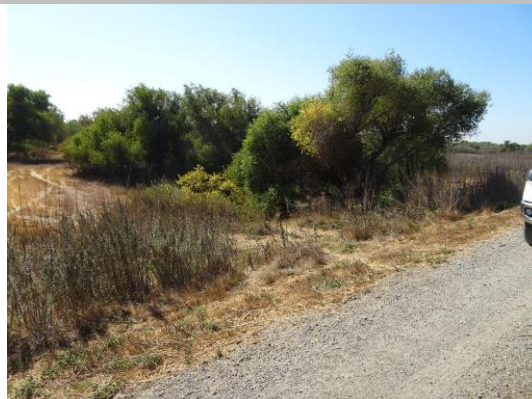
Photo 2 of 3 : UCIP_FA_2022_70661_90698.jpg

WS view: View of WS toe from levee crown. Headwall, pipe, and flapgate not visible from levee crown.

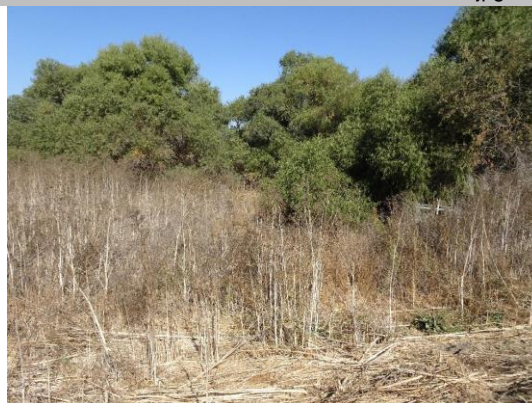
Photo 3 of 3 : UCIP_FA_2022_70661_90697.jpg

LS view: View toward LS toe. Slidegate visible through dense vegetation

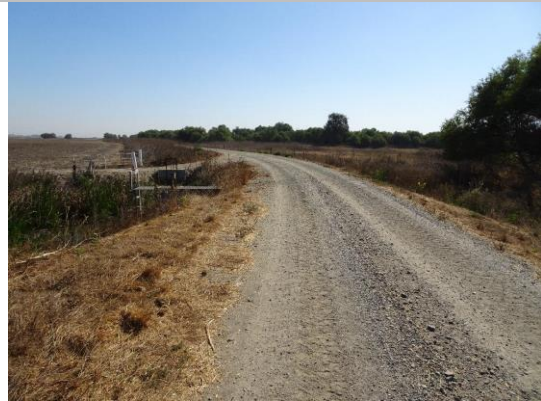
Photo 1 of 3 : UCIP_FA_2022_70662_90702.jpg

Comment Code						
Inspector Comment						
DS_ID:19613 FS_ID:70662 EP_NO: N/A Repair Type: Non-Urgent EVAL Issue: Crossing Status: Found UCIP Comments: 10/20/2020 Record remains Non-Urgent. Dense vegetation on WS toe, recommend removal for proper inspection. Minor surface erosion visible on the LS toe near the standpipe. No permit was found authorizing this encroachment. CVFPB will need to review crossing to determine owner. DWR DMP internal inspection is pending and scheduled for 2021. (B. Singh - GEI, O. Magana - DWR UCIP)04/08/2014 Dense vegetation limits the inspector's visibility to identify signs of pipe failure (leaks) along the slope. Recommend removing vegetation along pipe alignment to conduct proper inspection of structure and appurtenances. (W. Wylie - DWR UCIP) FIELD_STRUCT_DESC: 24-inch corrugated metal (CM) gravity drainage pipe through the levee, 9.5 feet below the crown. Flap gate on the waterside (WS) end. Slide gate on the landside (LS) end next to a 48-inch concrete riser unit with walkway over the top. Brass cap No. 90 bench mark (BM) on the headwall on the LS. [Additional Reference(s): DWR Levee Log, 2002, (HLM 6.44). USACE San Joaquin O&M Manual, Unit No. 601, Part No. 1, (SJR601.1), 1967, Revised 25 May 2011, (HLM 6.40)]. FS Date: 10/20/2020

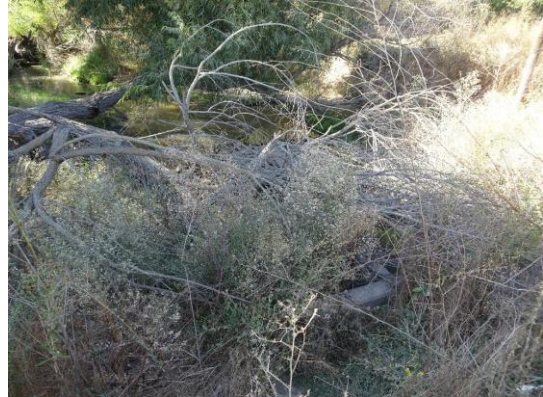
Photo 2 of 3 : UCIP_FA_2022_70662_90706.jpg

WS view: Inspection of WS headwall, pipe, and flapgate inhibited by dense vegetation

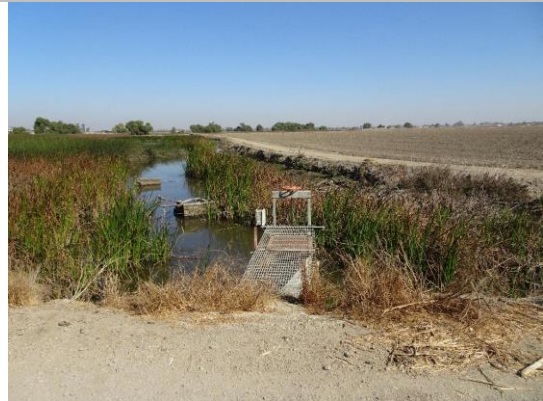
Photo 3 of 3 : UCIP_FA_2022_70662_90703.jpg

LS view: Metal walkway and slidegate visible on LS toe.

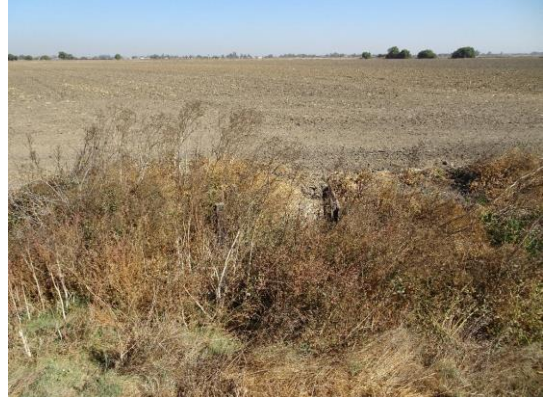
Photo 2 of 3 : UCIP_FA_2022_70663_90713.jpg

LS view: Dense vegetation on LS limiting view of wooden barrier around drop-inlet.

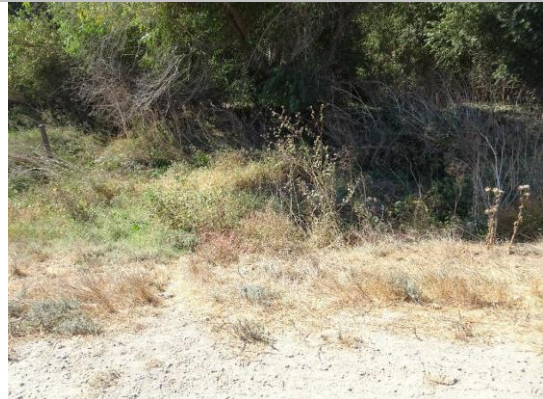
Photo 3 of 3 : UCIP_FA_2022_70663_90708.jpg

WS view: Pipe and flapgate at WS toe not visible from levee crown due to dense vegetation

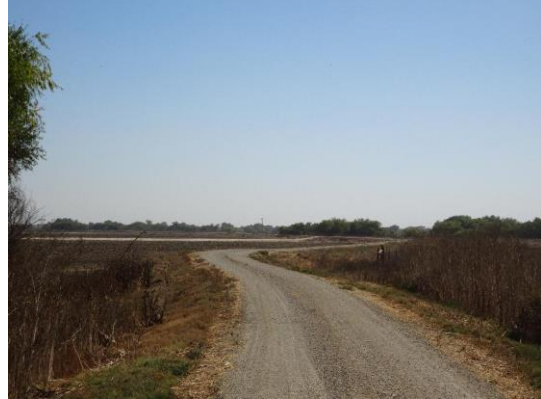
Photo 1 of 3 : UCIP_FA_2022_70664_90726.jpg

DS_ID:19615
FS_ID:70664
EP_NO: N/A
Repair Type: Urgent
EVAL Issue: 1, Pipe Integrity
Crossing Status: Found
UCIP Comments: 10/20/2020 Record has been updated from Non-Urgent to Urgent. Heavy corrosion present with visible holes found at the WS outlet near flap gate. Surface erosion present on the LS slope just upstream of slide gate. Evidence of surface erosion on the WS slope (vertical slope) was present approximately 15 feet downstream of the pipe. Plastic sheeting has been placed to prevent further erosion by LMA (assumed). Recommend notifying DWR Levee Inspector to monitor progress of surface erosion on the WS. No permit was found authorizing this encroachment. CVFPB will need to review crossing to determine owner. DWR DMP internal inspection is pending and scheduled for 2021. (B. Singh - GEI, O. Magana - DWR UCIP)07/19/2016 Potential LS slope damage--difficult to determine due to dense vegetation. Limited access on WS toe due to wire fence. (O. Magana - DWR UCIP)04/08/2014 Slide gate blocked by debris at LS toe. Flapgate won't close because of debris. Dense vegetation limits the inspector's visibility to identify signs of pipe failure (leaks) along the slope. Recommend removing vegetation along pipe alignment to conduct proper inspection of structure and appurtenances. (W. Wylie - DWR UCIP)

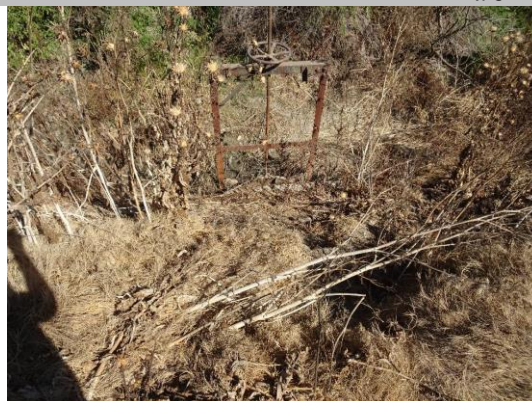
Photo 2 of 3 : UCIP_FA_2022_70664_90728.jpg

LS view: Surface erosion above LS headwall

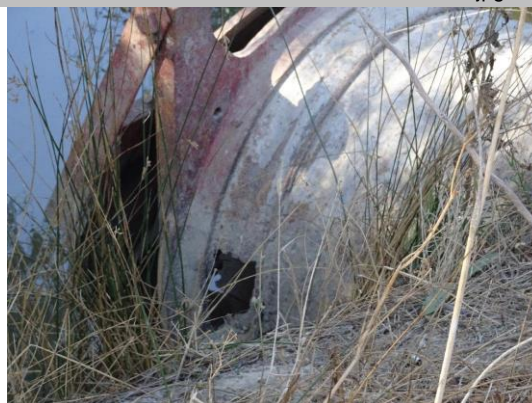
Photo 3 of 3 : UCIP_FA_2022_70664_90723.jpg

WS view: Extensive corrosion visible at WS invert

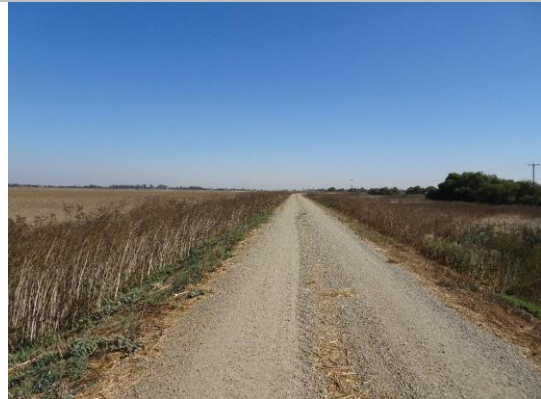
Photo 1 of 3 : UCIP_FA_2022_70667_90738.jpg

DS_ID:19618
FS_ID:70667
EP_NO: N/A
Repair Type: Urgent
EVAL Issue: 1, Pipe Integrity
Crossing Status: Found
UCIP Comments: 10/20/2020 Record has been updated from Non-Urgent to Urgent. DWR DMP has found integrity issues, LOF between 5 and 6. Crossing will be monitored until funding becomes available to address. Topography of WS toe has changed over time with sediment build-up preventing proper drainage. At the pipe outlet there is a gradual ground elevation change that causes the water to pond against the flap gate. No permit was found authorizing this encroachment. CVFPB will need to review crossing to determine owner. (B. Singh - GEI, O. Magana - DWR UCIP)04/08/2014 Dense vegetation limits the inspector's visibility to identify signs of pipe failure (leaks) along the slope. Recommend removing vegetation along pipe alignment to conduct proper inspection of structure and appurtenances. (W. Wylie - DWR UCIP)

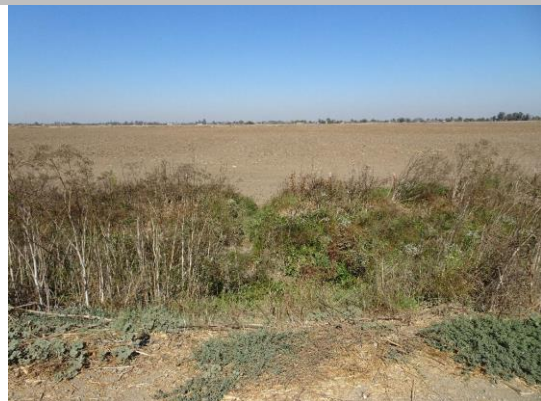
Photo 2 of 3 : UCIP_FA_2022_70667_90739.jpg

LS view: Headwall not visible at LS toe from levee crown due to vegetation

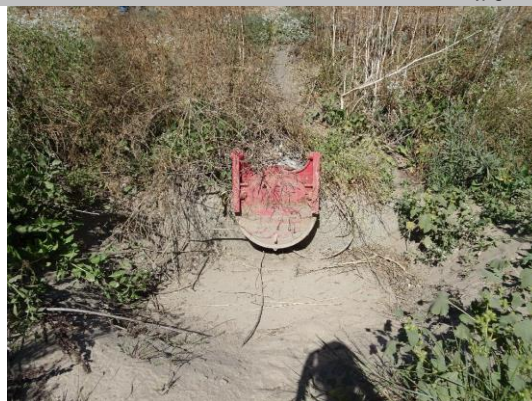
Photo 3 of 3 : UCIP_FA_2022_70667_90736.jpg

WS view: Pipe, flapgate and headwall at WS toe. Flapgate damaged and non-functional

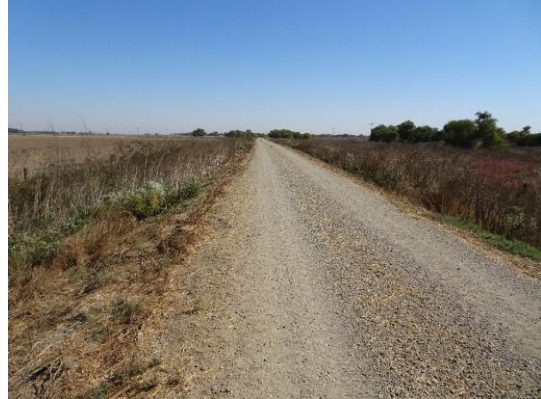
Photo 1 of 3 : UCIP_FA_2022_70668_90744.jpg

Comment Code						
Inspector Comment						
DS_ID:19619 FS_ID:70668 EP_NO: N/A Repair Type: Urgent EVAL Issue: 1, Pipe Integrity Crossing Status: Found UCIP Comments: 10/20/2020 Record has been updated from Non-Urgent to Urgent. Sloughing observed on the LS slope above headwall. DWR DMP has found integrity issues, LOF between 5 and 6. Crossing will be monitored until funding becomes available to address. No permit was found authorizing this encroachment. CVFPB will need to review crossing to determine owner. (B. Singh - GEI, O. Magana - DWR UCIP)04/08/2014 Dense vegetation limits the inspector's visibility to identify signs of pipe failure (leaks) along the slope. Recommend removing vegetation along pipe alignment to conduct proper inspection of structure. (W. Wylie - DWR UCIP) FIELD_STRUCT_DESC: 24-inch corrugated metal (CM) gravity drainage pipe through the levee, 10.0 feet below the crown. Flap gate on the waterside (WS) end. Brass cap No. 80 bench mark (BM) on the headwall on the landside (LS). [Additional Reference(s): DWR Levee Log, 2002, (HLM 7.70). USACE San Joaquin O&M Manual, Unit No. 601, Part No. 1, (SJR601.1), 1967, Revised 25 May 2011, (HLM 7.69)]. FS Date: 10/20/2020

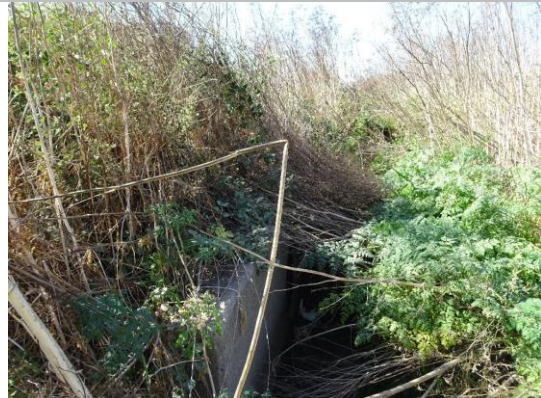
Photo 2 of 3 : UCIP_FA_2022_70668_90747.jpg

LS view: Headwall at LS toe. Dense vegetation blocking view

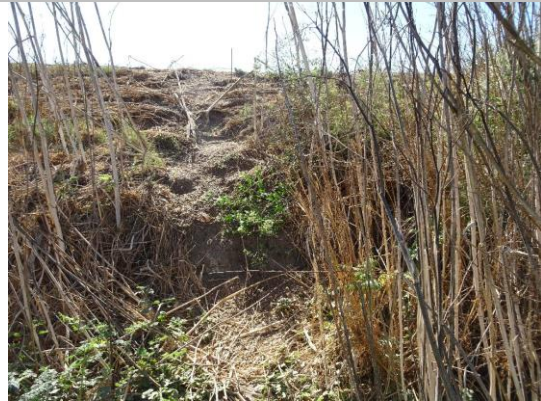
Photo 3 of 3 : UCIP_FA_2022_70668_90749.jpg

LS view: Sloughing above headwall and pipe on LS slope

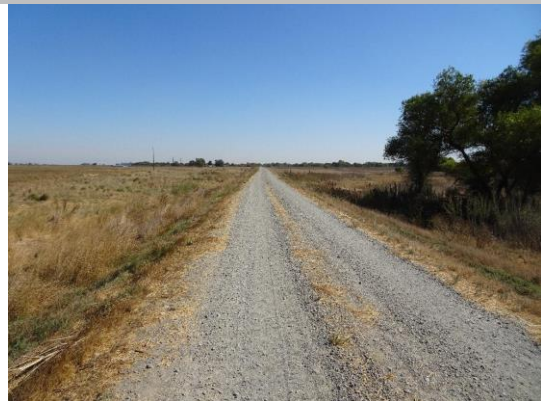
Photo 1 of 3 : UCIP_FA_2022_70669_90750.jpg

DS_ID:19620
FS_ID:70669
EP_NO: N/A
Repair Type: Non-Urgent
EVAL Issue: 5, Pipe Damage
Crossing Status: Found
UCIP Comments: 10/20/2020 Record remains Non-Urgent. DWR DMP has found integrity issues, LOF between 4 and 5. Corrosion in pipe visible on the LS toe. Crossing will be monitored until funding becomes available for rehabilitation. No permit was found authorizing this encroachment. CVFPB will need to review crossing to determine owner. (B. Singh - GEI, O. Magana - DWR UCIP)04/09/2014 Dense vegetation limits the inspector's visibility to identify signs of pipe failure (leaks) along the slope. Recommend removing vegetation along pipe alignment to conduct proper inspection of structure. (W. Wylie - DWR UCIP)
FIELD_STRUCT_DESC: 24-inch corrugated metal (CM) gravity drainage pipe through the levee, 8.0 feet below the crown. Flap gate on the waterside (WS) end. Brass cap No. 80 bench mark (BM) on the headwall on the landside (LS). [Additional Reference(s): DWR Levee Log, 2002, (HLM 8.09). USACE San Joaquin O&M Manual, Unit No. 601, Part No. 1, (SJR601.1), 1967, Revised 25 May 2011, (HLM 8.07)].

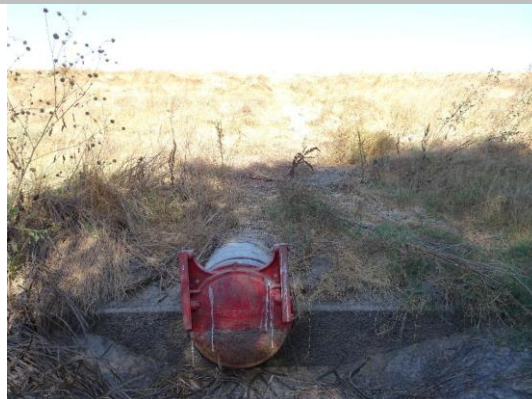
Photo 2 of 3 : UCIP_FA_2022_70669_90755.jpg

Pipe, flapgate, and headwall at WS toe

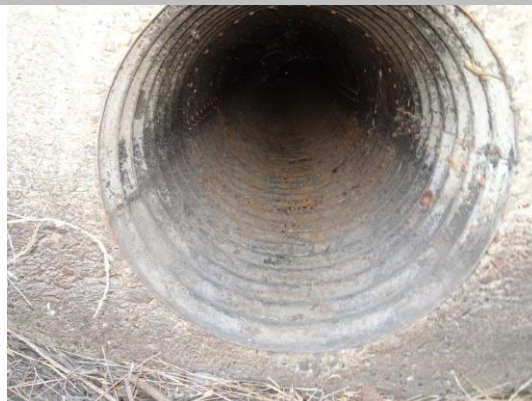
Photo 3 of 3 : UCIP_FA_2022_70669_90753.jpg

Headwall and pipe at LS toe. Visible corrosion in pipe.

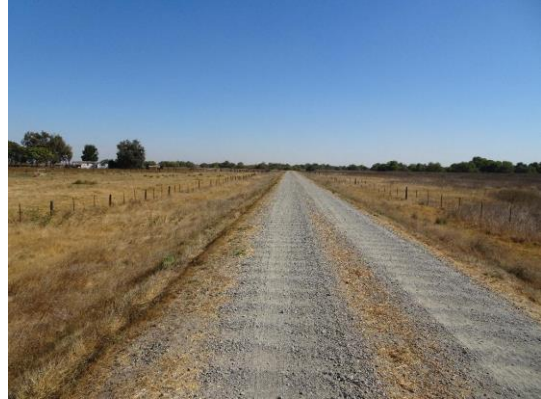
Photo 1 of 3 : UCIP_FA_2022_70670_90757.jpg

DS_ID:19621
FS_ID:70670
EP_NO: N/A
Repair Type: Non-Urgent
EVAL Issue: 5, Pipe Damage
Crossing Status: Found
UCIP Comments: 10/20/2020 Record remains Non-Urgent. DWR DMP has found integrity issues, LOF between 4 and 5. Crossing will be monitored until funding becomes available for rehabilitation. No permit was found authorizing this encroachment. CVFPB will need to review crossing to determine owner. (B. Singh - GEI, O. Magana - DWR UCIP)04/09/2014 Dense vegetation limits the inspector's visibility to identify signs of pipe failure (leaks) along the slope. Recommend removing vegetation along pipe alignment to conduct proper inspection of structure. Sediment buildup at landward toe. (W. Wylie - DWR UCIP) FIELD_STRUCT_DESC: 24-inch corrugated metal (CM) gravity drainage pipe through the levee, 9.5 feet below the crown. Flap gate on the waterside (WS) end. Brass cap No. 80 bench mark (BM) on the headwall on the landside (LS). [Additional Reference(s): DWR Levee Log, 2002, (HLM 8.43). USACE San Joaquin O&M Manual, Unit No. 601, Part No. 1, (SJR601.1), 1967, Revised 25 May 2011, (HLM 8.41)]. FS Date: 10/20/2020

Overview of levee crown, looking US

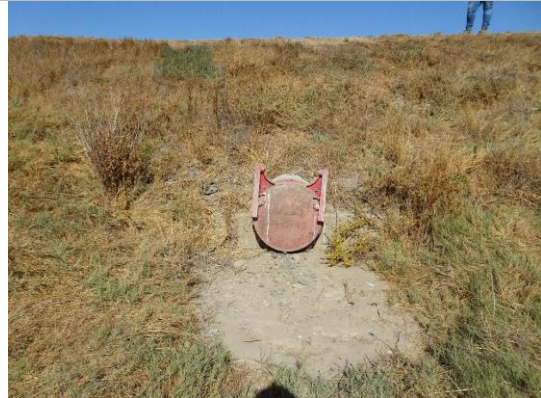
Photo 2 of 3 : UCIP_FA_2022_70670_90756.jpg

WS view: Pipe, flapgate, and headwall at WS toe

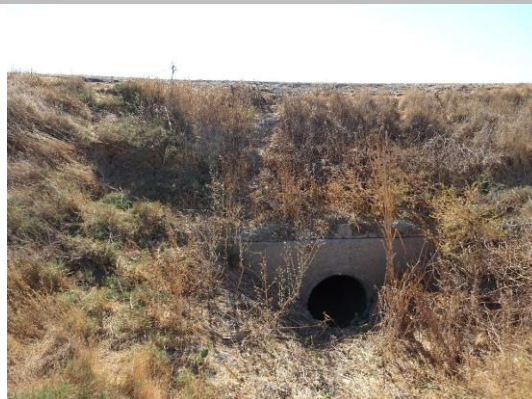
Photo 3 of 3 : UCIP_FA_2022_70670_90762.jpg

LS view: Pipe, headwall, and slope from LS toe

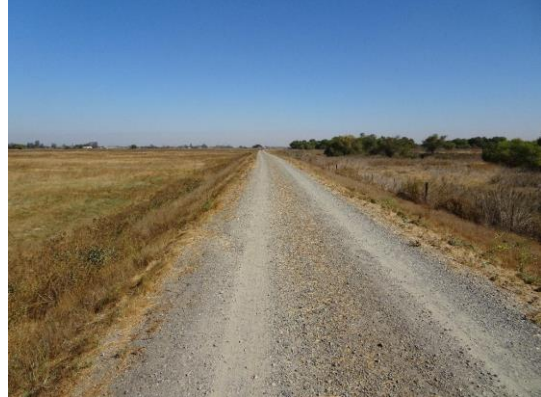
Photo 1 of 3 : UCIP_FA_2022_70672_90770.jpg

DS_ID:19622
FS_ID:70672
EP_NO: N/A
Repair Type: Non-Urgent
EVAL Issue:
Crossing Status: Found
UCIP Comments: 10/20/2020 Record has been updated from No Action Needed to Non-Urgent. Large burrow hole observed approximately 100 feet downstream of the pipe, on LS shoulder of the levee crown. No permit was found authorizing this encroachment. CVFPB will need to review crossing to determine owner. DWR DMP has not found internal issues, LOF between 1 and 2. Recommend inspection in 5 years. (B. Singh - GEI, O. Magana - DWR UCIP)
FIELD_STRUCT_DESC: 24-inch corrugated metal (CM) gravity drainage pipe through the levee, 9.0 feet below the crown. Flap gate on the waterside (WS) end. Brass cap No. 80 bench mark (BM) on the headwall on the landside (LS). [Additional Reference(s): DWR Levee Log, 2002, (HLM 8.62). USACE San Joaquin O&M Manual, Unit No. 601, Part No. 1, (SJR601.1), 1967, Revised 25 May 2011, (HLM 8.61)].

Overview of levee crown, looking US

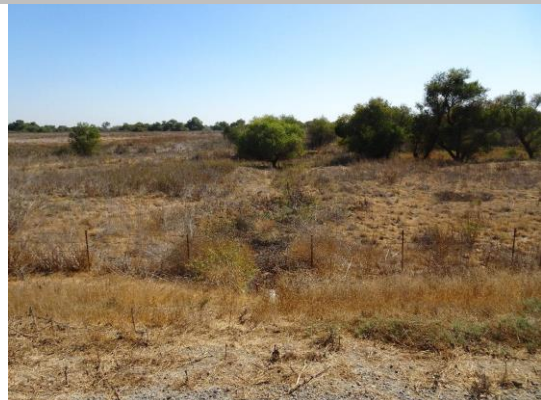
Photo 2 of 3 : UCIP_FA_2022_70672_90772.jpg

WS view: Pipe and flapgate visible on WS toe

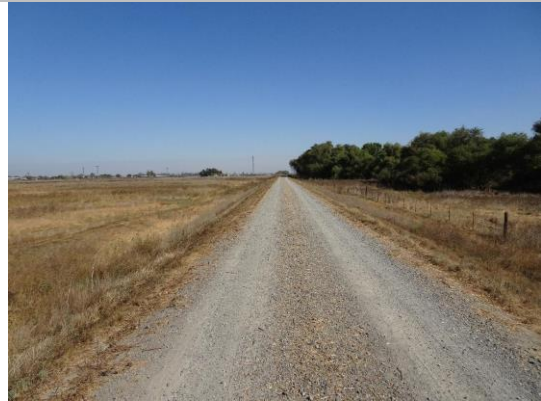
Photo 1 of 3 : UCIP_FA_2022_70673_90778.jpg

DS_ID:19623
 FS_ID:70673
 EP_NO: N/A
 Repair Type: Non-Urgent
 EVAL Issue:
 Crossing Status: Found
 UCIP Comments: 10/20/2020 Record remains Non-Urgent. No permit was found authorizing this encroachment. CVFPB will need to review crossing to determine owner. DWR DMP has not found internal issues, LOF between 1 and 2. Recommend inspection in 5 years. (B. Singh - GEI, O. Magana - DWR UCIP)04/09/2014 Dense vegetation limits the inspector's visibility to identify signs of pipe failure (leaks) along the slope. Recommend removing vegetation along pipe alignment to conduct proper inspection of structure. (W. Wylie - DWR UCIP)
 FIELD_STRUCT_DESC: 24-inch corrugated metal (CM) gravity drainage pipe through the levee, 9.1 feet below the crown. Flap gate on the waterside (WS) end. Brass cap No. 80 bench mark (BM) on the headwall on the landside (LS). [Additional Reference(s): DWR Levee Log, 2002, (HLM 8.95). USACE San Joaquin O&M, Unit No. 601, Part No. 1, (SJR601.1), 1967, Revised 25 May 2011, (HLM 8.93)].

Overview of levee crown, looking US

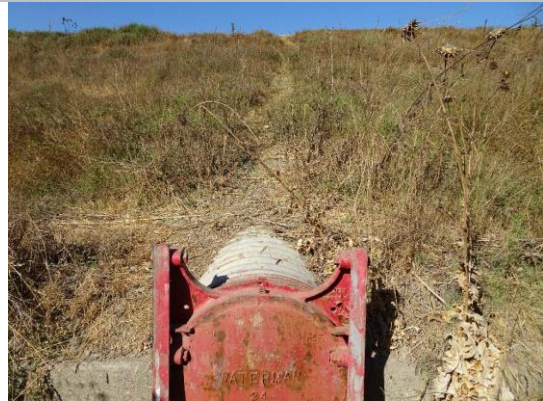
Photo 2 of 3 : UCIP_FA_2022_70673_90777.jpg

WS view: Pipe, flapgate, headwall, and slope at WS toe

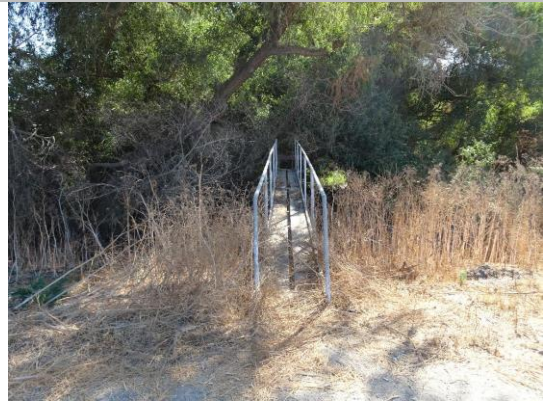
Photo 2 of 3 : UCIP_FA_2022_70674_90784.jpg

Comment Code					
Inspector Comment					
DS_ID:19624 FS_ID:70674 EP_NO: 12156 Repair Type: Urgent EVAL Issue: 3a, Flood Risk Crossing Status: Found UCIP Comments: 10/20/2020 Record remains Urgent. There is no operating gate that will prevent flows from the WS to LS. Dense vegetation prevented a full inspection of this crossing. Need to contact owner to clear the dense vegetation on both the WS and the LS to be able to perform proper inspection of crossing. DWR DMP has completed a geophysical study in this area and plans to complete an internal inspection of this pipe. The pipe is scheduled for an internal inspection in 2021. (B. Singh - GEI, O. Magana - DWR UCIP)11/01/2018 Dense vegetation prevented a full inspection of this crossing. Assumed crossing remains the same as the 2016 inspection. Crossing remains Urgent due to signs of pipe being rusted through visible from the WS. Need to contact owner to clear the dense vegetation on both the WS and the LS to be able to perform proper inspection of crossing. (O. Magana - DWR UCIP)07/19/2016 same as previous inspection--pipe rusted through. Sediment visible inside LS pipe; walkway wood panels have dry rot and appears to be unsafe to use. (O. Magana - DWR UCIP)04/09/2014 Slide gate rusted through and open on WS toe. Inlet appears to be obscured or covered in soil at LS toe. Also dense vegetation on waterward and landward sides. Need to contact owner to contact CVFPB to address issue. (W. Wylie - DWR UCIP) FIELD_STRUCT_DESC: 30-inch reinforced concrete (RC) gravity drainage pipe containing a 26-inch steel pipe through the levee, 7.3 feet below the crown. Annular space grouted. Two concrete cutoff walls in the center of the levee. Slide gate with elevated walkway access on the waterside (WS) end. 6-inch-thick concrete headwall on the WS end. Concrete wing walls on each end. (30-inch drainage pipe with a valve authorized under Permit No. 12156, 1977 - Merquin County Water District. Additional Related Permit(s): Permit No. 12156-A, 1978 - Merquin County Water District). [Additional Reference(s): DWR Levee Log, 2002, (HLM 9.01)]. FS Date: 10/20/2020

WS view: View toward WS toe

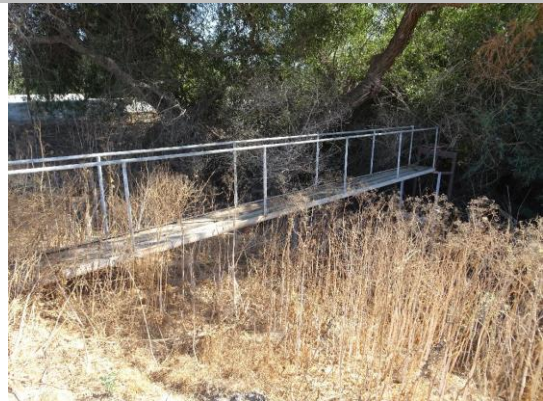
Photo 3 of 3 : UCIP_FA_2022_70674_90786.jpg

WS view: Elevated walkway across WS slope

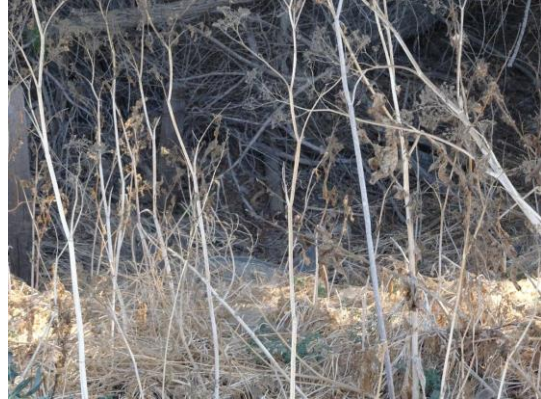
Photo 3 of 3 : UCIP_FA_2022_70675_92420.jpg

Comment Code					
Inspector Comment					
DS_ID:19625 FS_ID:70675 EP_NO: N/A Repair Type: Non-Urgent EVAL Issue: Crossing Status: Found UCIP Comments: 10/20/2020 Record remains Non-Urgent. As in previous inspection, dense vegetation inhibited proper inspection of the pipe and slope. No permit was found authorizing this encroachment. CVFPB will need to review crossing to determine owner. DWR DMP internal inspection is pending and scheduled for 2021. (B. Singh - GEI, O. Magana - DWR UCIP)04/09/2014 Dense vegetation limits the inspector's visibility to identify signs of pipe failure (leaks) along the slope. Recommend removing vegetation along pipe alignment to conduct proper inspection of structure. Some sediment buildup in pipe. (W. Wylie - DWR UCIP) FIELD_STRUCT_DESC: 36-inch corrugated metal (CM) gravity drainage pipe through the levee, 10.0 feet below the crown. Flap gate on the waterside (WS) end. Brass cap No. 80 bench mark (BM) on the headwall on the landside (LS). [Additional Reference(s): DWR Levee Log, 2002, (HLM 9.01). USACE San Joaquin O&M Manual, Unit No. 601, Part No. 1, (SJR601.1), 1967, Revised 25 May 2011, (HLM 9.00)]. FS Date: 10/20/2020

WS view: pipe visible through dense vegetation.

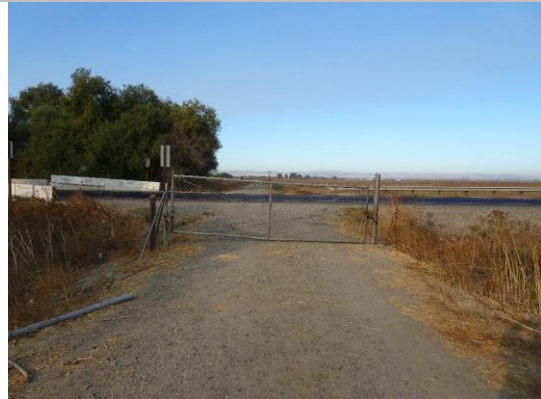
Photo 1 of 3 : UCIP_FA_2022_70676_90906.jpg

DS_ID:19626
 FS_ID:70676
 EP_NO: N/A
 Repair Type: Non-Urgent
 EVAL Issue:
 Crossing Status: Found
 UCIP Comments: 10/21/2020 Record remains Non-Urgent. Dense vegetation inhibited proper inspection of pipe condition. No permit was found authorizing this encroachment. CVFPB will need to review crossing to determine owner. DWR DMP internal inspection is pending and scheduled for 2021. (B. Singh - GEI, O. Magana - DWR UCIP)04/09/2014 Dense vegetation limits the inspector's visibility to identify signs of pipe failure (leaks) along the slope. Recommend removing vegetation along pipe alignment to conduct proper inspection of structure. (W. Wylie - DWR UCIP)
 FIELD_STRUCT_DESC: 24-inch corrugated metal (CM) gravity drainage pipe through the levee, 10.0 feet below the crown. Flap gate on the waterside (WS) end. Brass cap No. 80 bench mark (BM) on the headwall on the landside (LS). [Additional Reference(s): DWR Levee Log, 2002, (HLM 9.03). USACE San Joaquin O&M Manual, Unit No. 601, Part No. 1, (SJR601.1), 1967, Revised 25 May 2011, (HLM 9.03)].

Overview of levee crown looking downstream.

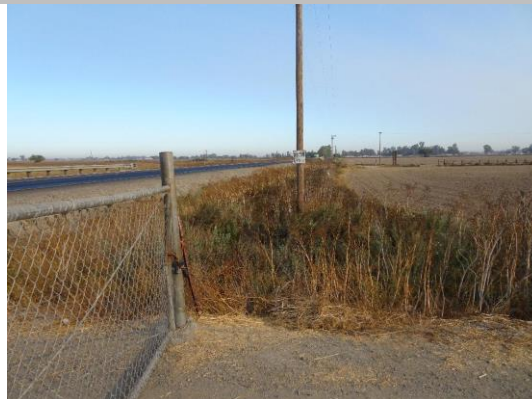
Photo 2 of 3 : UCIP_FA_2022_70676_90907.jpg

LS view: overview of LS

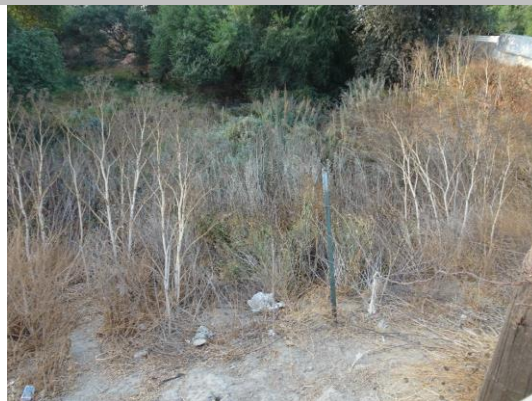
Photo 3 of 3 : UCIP_FA_2022_70676_90909.jpg

WS view: overview of WS

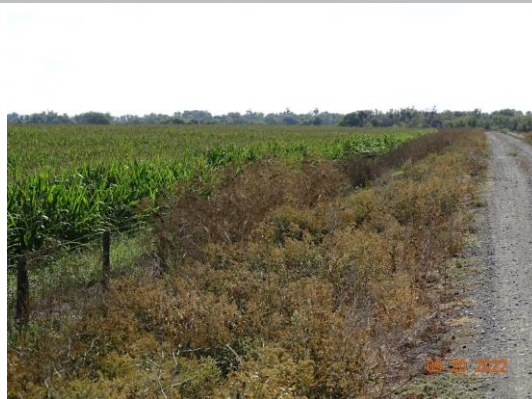
Photo 1 of 1 : FA_2022_NA0010_118_131_20221007_00297.jpg

LM Start	9.00	Rating **	U	Issue No.	131
LM End	9.63	Issue Type +	Ma	Location *	LS
Category	Earthen Levee			GPS Latitude/Longitude	
				Start	End
Item	Vegetation			37.297505 °	37.294935 °
				-120.851055 °	-120.840629 °
DWR ID	DWR_NA0010_01_f_2022_131				
Comment Code					
V1 : Control annual grass and weeds on the levee slopes and easements.					
Inspector Comment

View of vegetation growing on the landside slope. (Fall 2022)

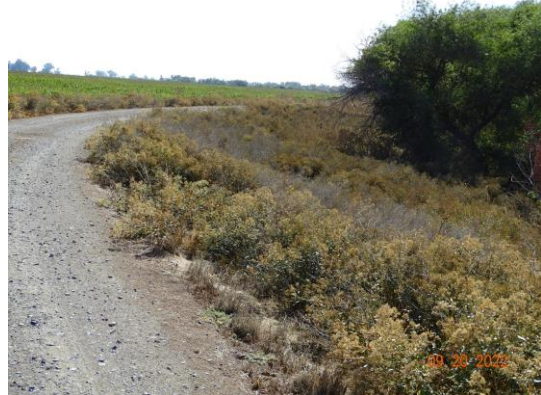
Photo 1 of 1 : FA_2022_NA0010_118_137_20221007_00298.jpg

LM Start	9.00	Rating **	U	Issue No.	137
LM End	9.63	Issue Type +	Ma	Location *	WS
Category	Earthen Levee			GPS Latitude/Longitude	
				Start	End
Item	Vegetation			37.297506 °	37.294935 °
				-120.851008 °	-120.840629 °
DWR ID	DWR_NA0010_01_f _ 2022_137				
Comment Code					
V1 : Control annual grass and weeds on the levee slopes and easements.					
Inspector Comment

View of the waterside slope looking upstream. (Fall 2022)

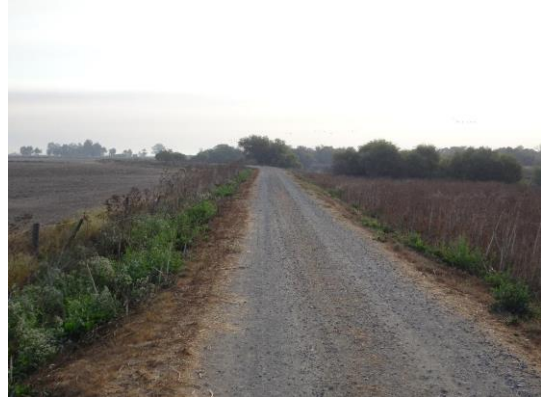
Photo 1 of 3 : UCIP_FA_2022_70677_90910.jpg

Comment Code					
Inspector Comment					
DS_ID:19627 FS_ID:70677 EP_NO: N/A Repair Type: Urgent EVAL Issue: 1, Pipe Integrity Crossing Status: Found UCIP Comments: 10/21/2020 Record has been updated from Non-Urgent to Urgent. DWR DMP has found integrity issues, LOF between 5 and 6. Scouring observed about 2 feet downstream of pipe at WS toe. Crossing will be monitored until funding becomes available to address. No permit was found authorizing this encroachment. CVFPB will need to review crossing to determine owner. (B. Singh - GEI, O. Magana - DWR UCIP)04/09/2014 Dense vegetation limits the inspector's visibility to identify signs of pipe failure (leaks) along the slope. Recommend removing vegetation along pipe alignment to conduct proper inspection of structure. (W. Wylie - DWR UCIP) FIELD_STRUCT_DESC: 24-inch corrugated metal (CM) gravity drainage pipe through the levee, 8.6 feet below the crown. Concrete drop inlet at the landside (LS) toe. Flap gate on the waterside (WS) end. Brass cap No. 80 bench mark (BM) on the headwall on the LS. [Additional Reference(s): DWR Levee Log, 2002, (HLM 9.39). USACE San Joaquin O&M Manual, Unit No. 601, Part No. 1, (SJR601.1), 1967, Revised 25 May 2011, (HLM 9.37)]. FS Date: 10/21/2020

Overview of levee crown

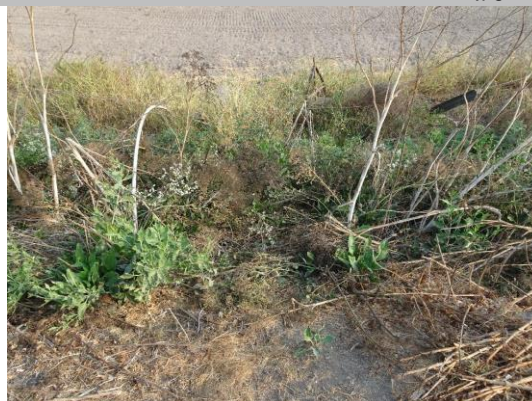
Photo 2 of 3 : UCIP_FA_2022_70677_90911.jpg

LS view: View of LS slope from levee crown

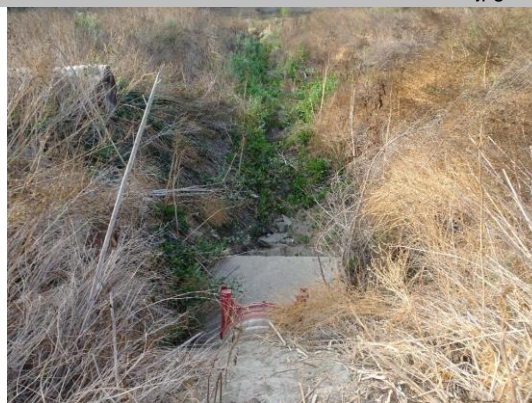
Photo 3 of 3 : UCIP_FA_2022_70677_90914.jpg

WS view: Pipe and flapgate at WS toe

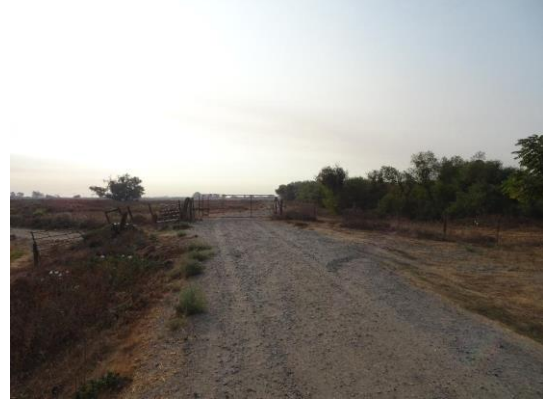
Photo 1 of 3 : UCIP_FA_2022_70678_90915.jpg

Comment Code					
Inspector Comment					
DS_ID:19628 FS_ID:70678 EP_NO: N/A Repair Type: Non-Urgent EVAL Issue: Crossing Status: Found UCIP Comments: 10/21/2020 Record has been updated from No Action Needed to Non-Urgent. No permit was found authorizing this encroachment. CVFPB will need to review crossing to determine owner. DWR DMP has not found internal issues, LOF between 1 and 2. Recommend inspection in 5 years. (B. Singh - GEI, O. Magana - DWR UCIP) FIELD_STRUCT_DESC: 24-inch corrugated metal (CM) gravity drainage pipe through the levee, 4.5 feet below the crown. Flap gate on the waterside (WS) end. Brass cap No. 80 bench mark (BM) on the headwall on the landside (LS). [Additional Reference(s): DWR Levee Log, 2002, (HLM 9.68). USACE San Joaquin O&M Manual, Unit No. 601, Part No. 1, (SJR601.1), 1967, Revised 25 May 2011, (HLM 9.67)]. FS Date: 10/21/2020

Overview of levee crown

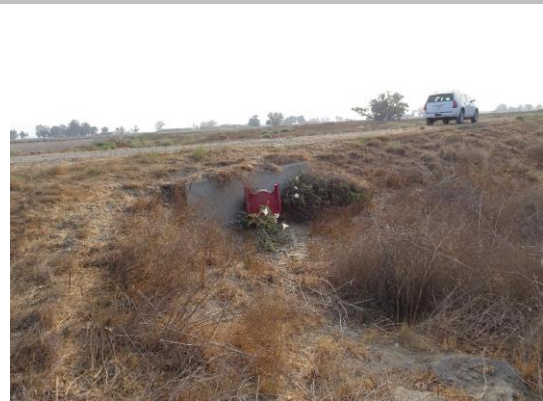
Photo 2 of 3 : UCIP_FA_2022_70678_90917.jpg

WS view: Pipe, flapgate, and headwall at WS toe

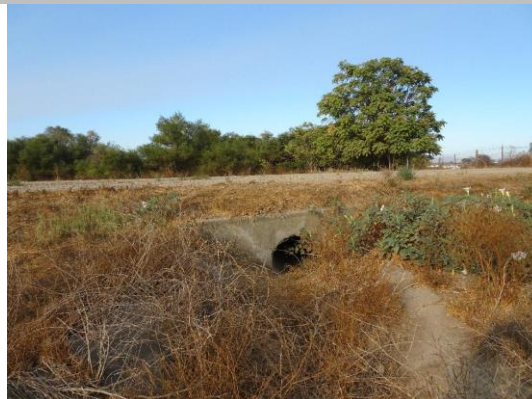
Photo 3 of 3 : UCIP_FA_2022_70678_90920.jpg

LS view: Pipe and headwall at LS toe

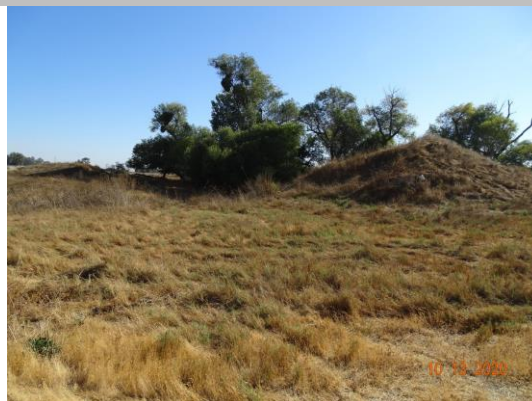
Photo 1 of 1 : FA_2022_NA0010_118_112_20220822_00013.jpg

Landowner degraded levee in the 1970's because water on LS was flooding his property. Landowner has prevented efforts to restore levee. LMA has stated that no water from the waterside of the levee has ever backed up through the degraded levee and caused flooding.

Looking east at the levee breach. (Fall 2020)

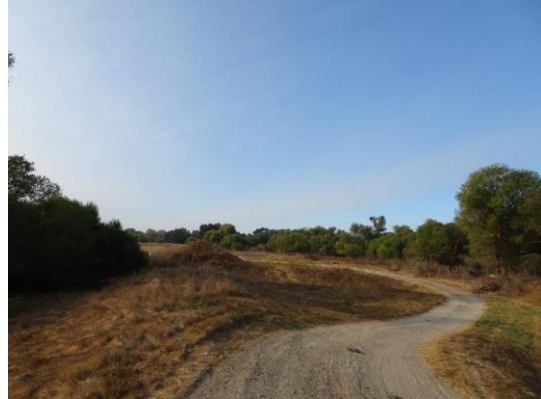
Photo 1 of 3 : UCIP_FA_2022_70680_91045.jpg

Comment Code					
Inspector Comment					
DS_ID:19556 FS_ID:70680 EP_NO: N/A Repair Type: Non-Urgent EVAL Issue: Crossing Status: Not Found UCIP Comments: 10/21/2020 Record has been updated from No Action Needed to Non-Urgent. No levee present at this location. Pipe referenced at this location does not exist. Only found two culverts at grade in the WS. No permit was found authorizing this encroachment. CVFPB will need to review crossing to determine owner. (B. Singh - GEI, O. Magana - DWR UCIP) FIELD_STRUCT_DESC: 24-inch corrugated metal (CM) gravity drainage pipe through the levee, 6.0 feet below the crown. Flap gate on the waterside (WS) end. Brass cap No. 70 bench mark (BM) on the headwall on the landside (LS). [Additional Reference(s): DWR Levee Log, 2002, (HLM 9.91). USACE San Joaquin O&M Manual, Unit No. 601, Part No. 1, (SJR601.1), 1967, Revised 25 May 2011, (HLM 9.93)]. FS Date: 10/21/2020

Overview of area looking upstream at levee breach.

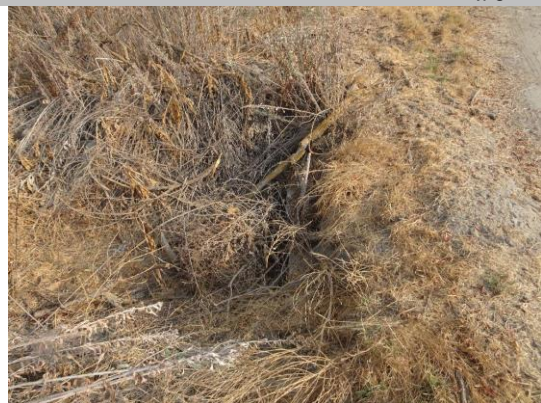
Photo 2 of 3 : UCIP_FA_2022_70680_91047.jpg

Culverts underneath access road visible on WS

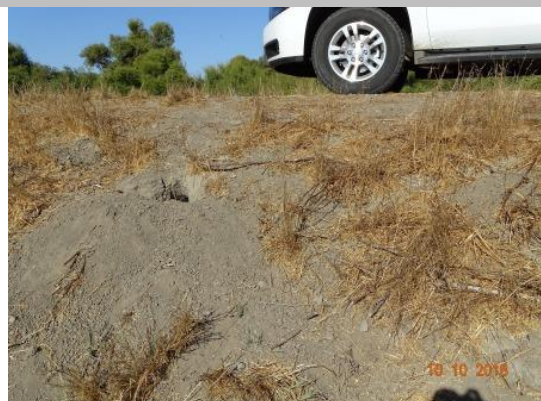
Photo 1 of 1 : FA_2022_NA0010_118_120_20220822_00020.jpg

LM Start	9.94	Rating **	U	Issue No.	120
LM End	9.97	Issue Type +	Ma	Location *	LS
Category	Earthen Levee			GPS Latitude/Longitude	
				Start	End
Item	Animal Control			37.290994 °	37.290673 °
				-120.839758 °	-120.839988 °
DWR ID	DWR_NA0010_01_f_2018_120				
Comment Code					
A3 : No rodents visible, but rodent burrows visible; need to backfill and compact or grout burrows.					
Inspector Comment					
Rodent burrows observed in this section with large amount of material displaced.

View of rodent burrow in the landside slope. (Fall 2018)

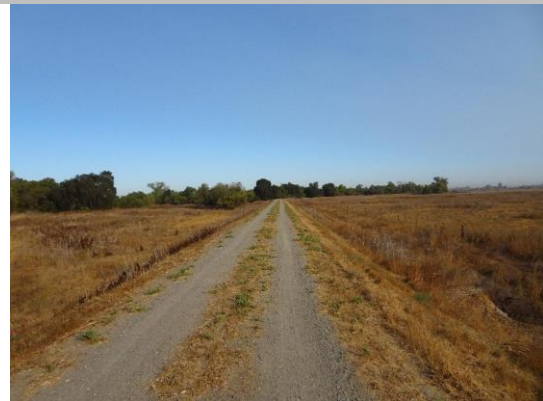
Photo 1 of 3 : UCIP_FA_2022_70681_90922.jpg

Comment Code						
Inspector Comment						
DS_ID:19629 FS_ID:70681 EP_NO: N/A Repair Type: Non-Urgent EVAL Issue: Crossing Status: Found UCIP Comments: 10/21/2020 Record remains Non-Urgent. No permit was found authorizing this encroachment. CVFPB will need to review crossing to determine owner. DWR DMP has not found internal issues, LOF between 1 and 2. Recommend inspection in 5 years. (B. Singh - GEI, O. Magana - DWR UCIP)04/09/2014 Dense vegetation blocks waterward and landward toes Recommend removing vegetation from both toes. Also sediment buildup in pipe visible from landward side. (W. Wylie - UCIP DMP) FIELD_STRUCT_DESC: 24-inch corrugated metal (CM) gravity drainage pipe through the levee, 9.0 feet below the crown. Flap gate on the waterside (WS) end. Brass cap No. 69 bench mark (BM) on the headwall on the landside (LS). [Additional Reference(s): DWR Levee Log, 2002, (HLM 10.24). USACE San Joaquin O&M Manual, Unit No. 601, Part No. 1, (SJR601.1), 1967, Revised 25 May 2011, (HLM 10.23)]. FS Date: 10/21/2020

Overview of levee crown

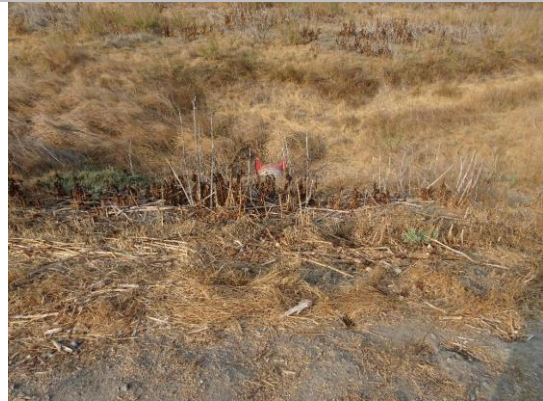
Photo 2 of 3 : UCIP_FA_2022_70681_90923.jpg

WS view: Pipe and flapgate visible at WS toe
