Flood Control Project Maintenance Levee Inspections

Fall 2022 Levee Maintenance Deficiency Summary Report

San Joaquin River Basin

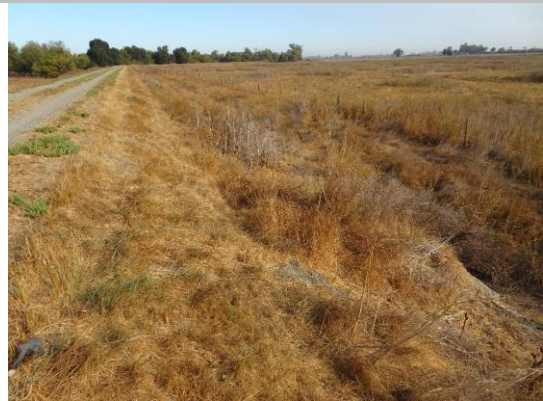
Photo 3 of 3 : UCIP_FA_2022_70681_90925.jpg

LS view: LS toe and pipe headwall

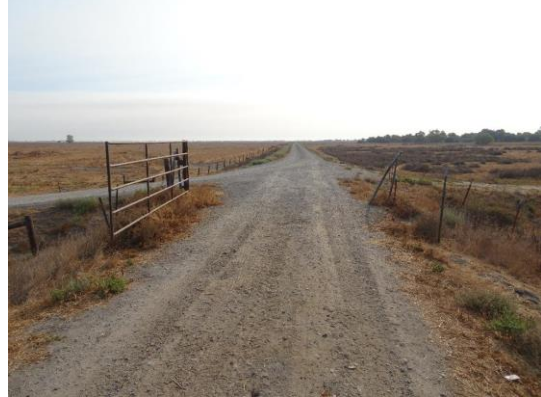
Photo 1 of 2 : UCIP_FA_2022_70682_90999.jpg

DS_ID:19630
FS_ID:70682
EP_NO: N/A
Repair Type: Non-Urgent
EVAL Issue:
Crossing Status: Found
UCIP Comments: 10/21/2020 Record has been updated from No Action Needed to Non-Urgent. No permit was found authorizing this encroachment. CVFPB will need to review crossing to determine owner. DWR DMP has not found internal issues, LOF between 1 and 2. Recommend inspection in 5 years. (B. Singh - GEI, O. Magana - DWR UCIP)
FIELD_STRUCT_DESC: 24-inch corrugated metal (CM) gravity drainage pipe through the levee, 7.0 feet below the crown. Flap gate on the waterside (WS) end. Brass cap No. 68 bench mark (BM) on the headwall on the landside (LS). [Additional Reference(s): DWR Levee Log, 2002, (HLM 10.73). USACE San Joaquin O&M Manual, Unit No. 601, Part No. 1, (SJR601.1), 1967, Revised 25 May 2011, (HLM 10.72)].
FS Date: 10/21/2020

Overview of levee crown looking upstream

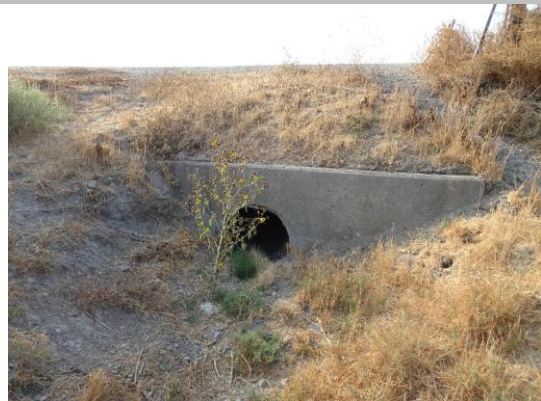
Photo 2 of 2 : UCIP_FA_2022_70682_91003.jpg

LS view: Pipe and headwall at LS toe

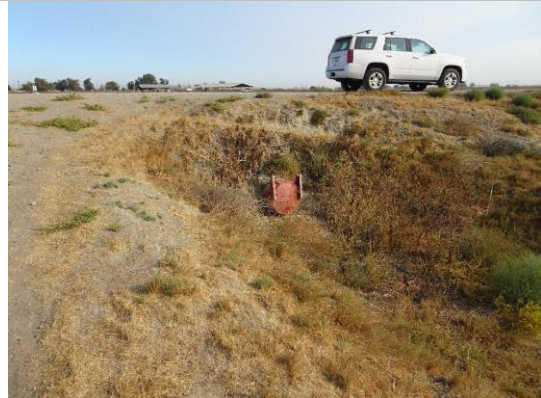
Photo 2 of 3 : UCIP_FA_2022_70683_91010.jpg

Comment Code					
Inspector Comment					
DS_ID:19631 FS_ID:70683 EP_NO: N/A Repair Type: Non-Urgent EVAL Issue: 5, Pipe Damage Crossing Status: Found UCIP Comments: 10/21/2020 Record has been updated from No Action Needed to Non-Urgent. DWR DMP has found integrity issues, LOF between 4 and 5. Crossing will be monitored until funding becomes available for rehabilitation. No permit was found authorizing this encroachment. CVFPB will need to review crossing to determine owner. Pipe material changes from CMP on the WS to concrete on the LS. (B. Singh - GEI, O. Magana - DWR UCIP) FIELD_STRUCT_DESC: 24-inch corrugated metal (CM) gravity drainage pipe through the levee, 7.0 feet below the crown. Flap gate on the waterside (WS) end. Brass cap No. 67 bench mark (BM) on the headwall on the landside (LS). Pipe material changes from CMP on the WS to concrete on the LS. [Additional Reference(s): DWR Levee Log, 2002, (HLM 10.74). USACE San Joaquin O&M Manual, Unit No. 601, Part No. 1, (SJR601.1), 1967, Revised 25 May 2011, (HLM 10.72)]. FS Date: 10/21/2020

WS view: Pipe and flapgate at WS toe

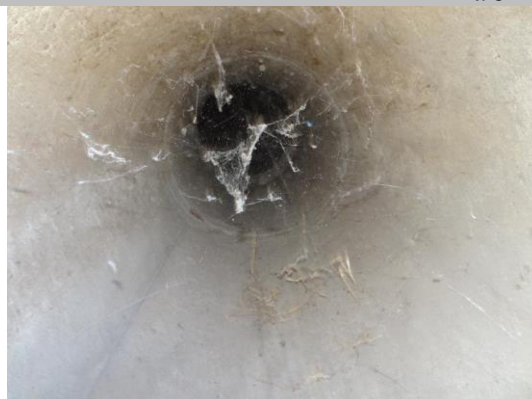
Photo 3 of 3 : UCIP_FA_2022_70683_91013.jpg

LS view: internal view of concrete pipe located on WS.

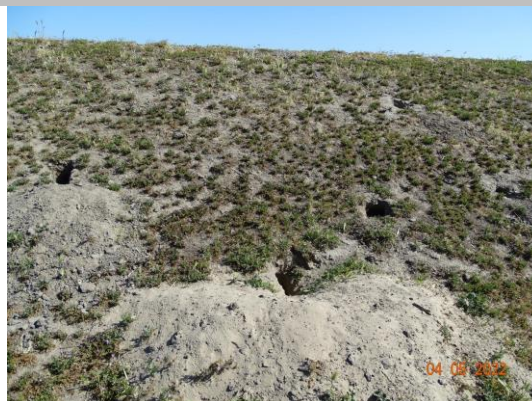
Photo 1 of 1 : FA_2022_NA0010_118_133_20220822_00021.jpg

LM Start	10.90	Rating **	U	Issue No.	133
LM End	10.90	Issue Type +	Ma	Location *	WS
Category	Earthen Levee			GPS Latitude/Longitude	
				Start	End
Item	Animal Control			37.282911 °	37.282911 °
				-120.829665 °	-120.829665 °
DWR ID	DWR_NA0010_01_s_2022_133				
Comment Code					
A3 : No rodents visible, but rodent burrows visible; need to backfill and compact or grout burrows.					
Inspector Comment

View of rodent burrows on the waterside slope. (Spring 2022)

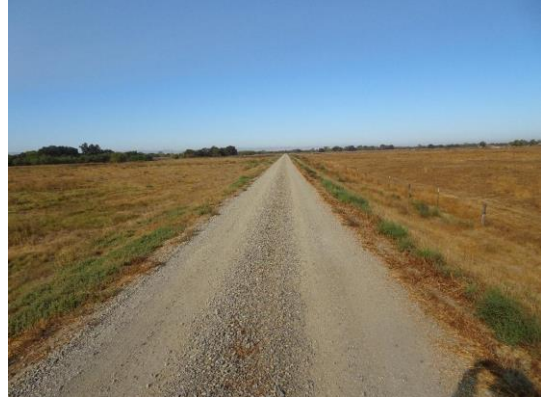
Photo 1 of 3 : UCIP_FA_2022_70684_90929.jpg

Comment Code						
Inspector Comment						
DS_ID:19632 FS_ID:70684 EP_NO: N/A Repair Type: Non-Urgent EVAL Issue: Crossing Status: Found UCIP Comments: 10/21/2020 Record remains Non-Urgent. No permit was found authorizing this encroachment. CVFPB will need to review crossing to determine owner. DWR DMP has not found internal issues, LOF between 1 and 2. Recommend inspection in 5 years. Dense vegetation previously recorded in the 2014 UCIP inspection has been cleared. (B. Singh - GEI, O. Magana - DWR UCIP)04/09/2014 Dense vegetation blocks landward headwall. Recommend removing excess vegetation on landward toe. (W. Wylie - DWR UCIP) FIELD_STRUCT_DESC: 24-inch corrugated metal (CM) gravity drainage pipe through the levee, 6.0 feet below the crown. Flap gate on the waterside (WS) end. Brass cap No. 66 bench mark (BM) on the headwall on the landside (LS). [Additional Reference(s): DWR Levee Log, 2002, (HLM 11.02). USACE San Joaquin O&M Manual, Unit No. 601, Part No. 1, (SJR601.1), 1967, Revised 25 May 2011, (HLM 11.00)]. FS Date: 10/21/2020

Overview of levee crown looking upstream

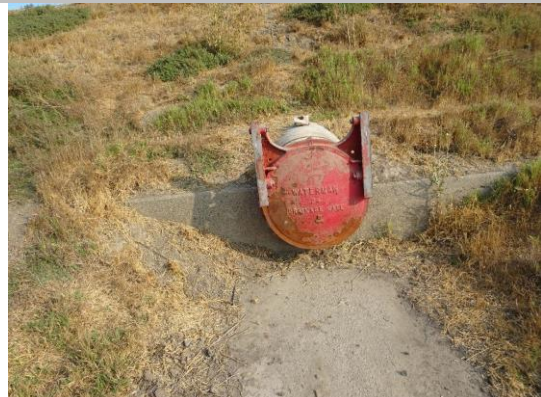
Photo 2 of 3 : UCIP_FA_2022_70684_90933.jpg

WS view: Pipe, flapgate, and headwall at WS toe

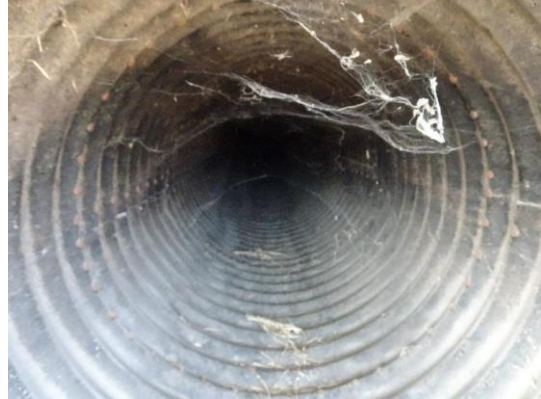
Photo 3 of 3 : UCIP_FA_2022_70684_90928.jpg

LS view: Pipe interior from LS toe

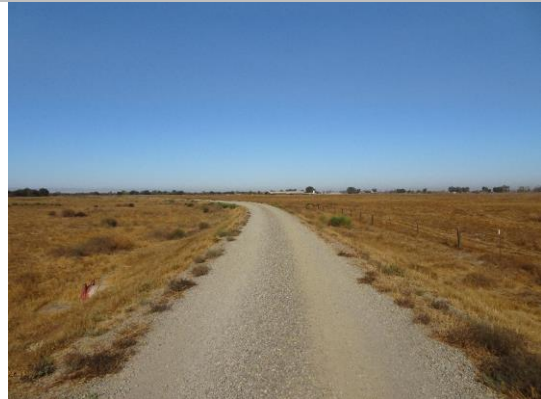
Photo 1 of 3 : UCIP_FA_2022_70685_90935.jpg

DS_ID:19633
 FS_ID:70685
 EP_NO: N/A
 Repair Type: Non-Urgent
 EVAL Issue:
 Crossing Status: Found
 UCIP Comments: 10/21/2020 Record has been updated from No Action Needed to Non-Urgent. No permit was found authorizing this encroachment. CVFPB will need to review crossing to determine owner. DWR DMP has not found internal issues, LOF between 1 and 2. Recommend inspection in 5 years. (B. Singh - GEI, O. Magana - DWR UCIP)
 FIELD_STRUCT_DESC: 24-inch corrugated metal (CM) gravity drainage pipe through the levee, 5.0 feet below the crown. Flap gate on the waterside (WS) end. Brass cap No. 65 bench mark (BM) on the headwall on the landside (LS). [Additional Reference(s): DWR Levee Log, 2002, (HLM 11.20). USACE San Joaquin O&M Manual, Unit No. 601, Part No. 1, (SJR601.1), 1967, Revised 25 May 2011, (HLM 11.18)].
 FS Date: 10/21/2020

Overview of levee crown, looking upstream

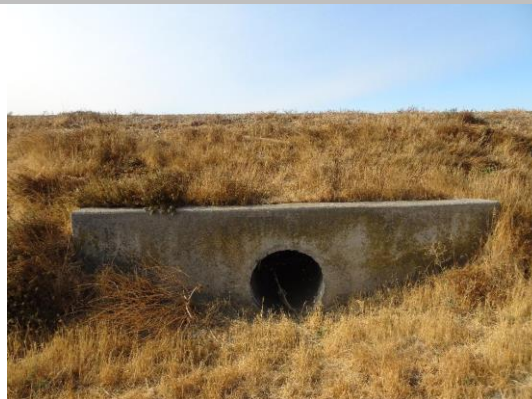
Photo 2 of 3 : UCIP_FA_2022_70685_90938.jpg

LS view: Pipe and headwall at LS toe

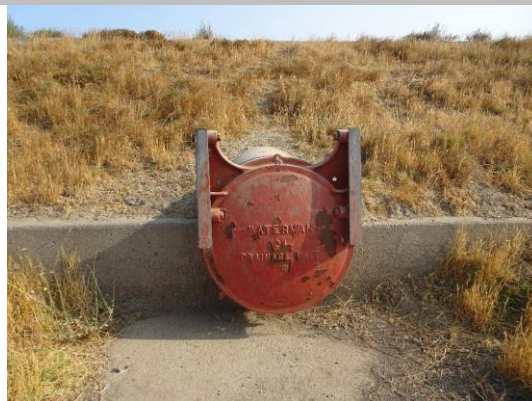
Photo 3 of 3 : UCIP_FA_2022_70685_90934.jpg

WS view: Pipe, flapgate, and headwall at WS toe

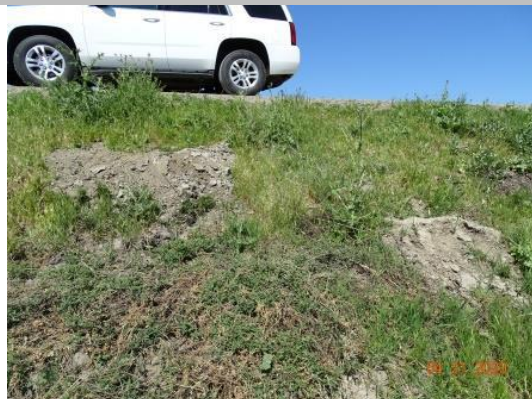
Photo 1 of 1 : FA_2022_NA0010_118_151_20220822_00024.jpg

LM Start	11.37	Rating **	M	Issue No.	151
LM End	11.37	Issue Type +	Ma	Location *	LS
Category	Earthen Levee			GPS Latitude/Longitude	
				Start	End
Item	Animal Control			37.275481 °	37.275481 °
				-120.826042 °	-120.826042 °
DWR ID	DWR_NA0010_01_s_2020_151				
Comment Code					
A1 : Exterminate rodents and backfill and compact or grout burrows.					
Inspector Comment

Rodent burrows in the landside slope. (Spring 2020)

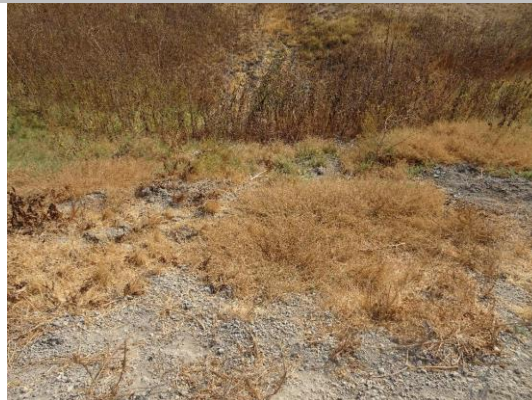
Photo 2 of 3 : UCIP_FA_2022_70686_90943.jpg

LS view: overview of LS slope.

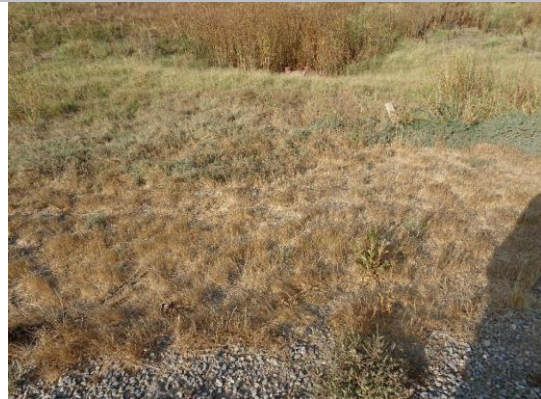
Photo 3 of 3 : UCIP_FA_2022_70686_90942.jpg

WS view: overview of WS slope. Pipe and flapgate visible

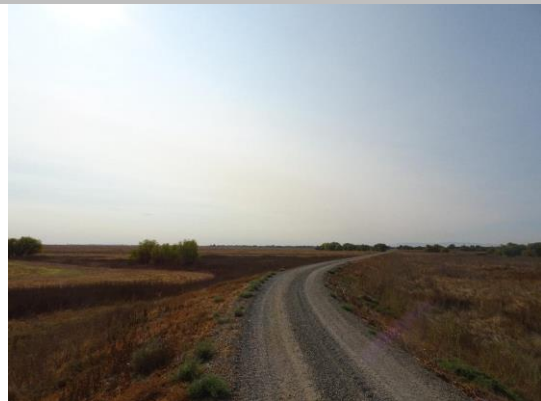
Photo 1 of 3 : UCIP_FA_2022_70687_92836.jpg

DS_ID:19634
 FS_ID:70687
 EP_NO: N/A
 Repair Type: Non-Urgent
 EVAL Issue: 5, Pipe Damage
 Crossing Status: Found
 UCIP Comments: 10/21/2020 Record remains Non-Urgent. Dense vegetation inhibited inspection of pipe and headwall on the LS toe. DWR DMP has found integrity issues, LOF between 4 and 5. Unable to locate pipe inlet on along the LS toe. Crossing will be monitored until funding becomes available for rehabilitation. No permit was found authorizing this encroachment. CVFPB will need to review crossing to determine owner. (B. Singh - GEI, O. Magana - DWR UCIP)04/25/2014 Need to contact owner--landward side has been buried. It appears that soil was removed from levee toe, immediately upstream, and used to pile soil at landward side at crossing. (O. Magana - DWR UCIP)
 FIELD_STRUCT_DESC: 24-inch corrugated metal (CM) gravity drainage pipe through the levee, 10.0 feet below the crown. Flap gate on the waterside (WS) end. Brass cap No. 62 bench mark (BM) on the headwall on the landside (LS). [Additional Reference(s): DWR Levee Log, 2002, (HLM 11.48). USACE San Joaquin O&M Manual, Unit No. 601, Part No. 1, (SJR601.1), 1967, Revised 25 May 2011, (HLM 11.48)].

Overview of levee crown looking upstream towards pipe crossing, photo 1 of 2.

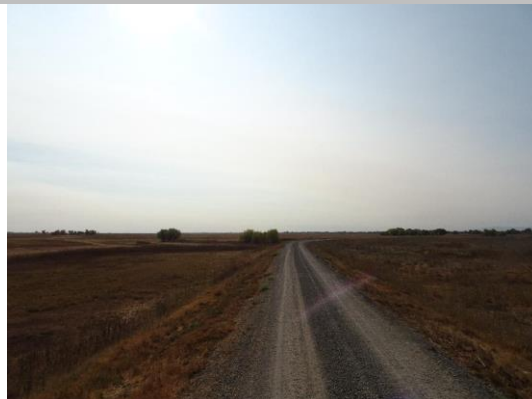
Photo 2 of 3 : UCIP_FA_2022_70687_90946.jpg

Overview of levee crown looking upstream towards pipe crossing, photo 2 of 2.

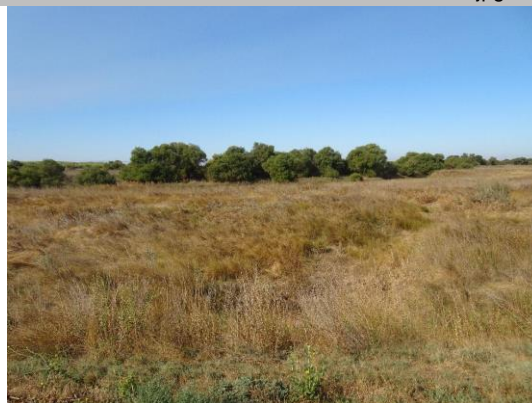
Photo 3 of 3 : UCIP_FA_2022_70687_90947.jpg

WS view: overview of WS.

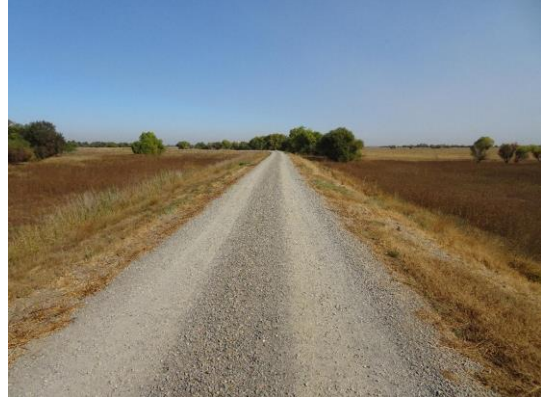
Photo 1 of 3 : UCIP_FA_2022_70689_90956.jpg

Comment Code						
Inspector Comment						
DS_ID:19636 FS_ID:70689 EP_NO: N/A Repair Type: Non-Urgent EVAL Issue: Crossing Status: Found UCIP Comments: 10/21/2020 Record remains Non-Urgent. Dense vegetation inhibited proper inspection of the pipe on the LS and WS toes. No permit was found authorizing this encroachment. CVFPB will need to review crossing to determine owner. DWR DMP internal inspection is pending and scheduled for 2021. (B. Singh - GEI, O. Magana - DWR UCIP)04/25/2014 Crossing is non-functional -- landward side is buried. Dense vegetation found on waterward slope. Recommend contacting owner to determine status of crossing. If crossing is no longer used need to coordinate with CVFPB for proper abandonment. (O. Magana - DWR UCIP) FIELD_STRUCT_DESC: 24-inch corrugated metal (CM) gravity drainage pipe through the levee, 12.4 feet below the crown. Flap gate on the waterside (WS) end. Brass cap No. 60 bench mark (BM) on the headwall on the landside (LS). [Additional Reference(s): DWR Levee Log, 2002, (HLM 12.12). USACE San Joaquin O&M Manual, Unit No. 601, Part No. 1, (SJR601.1), 1967, Revised 25 May 2011, (HLM 12.11)]. FS Date: 10/21/2020

Overview of levee crown looking upstream.

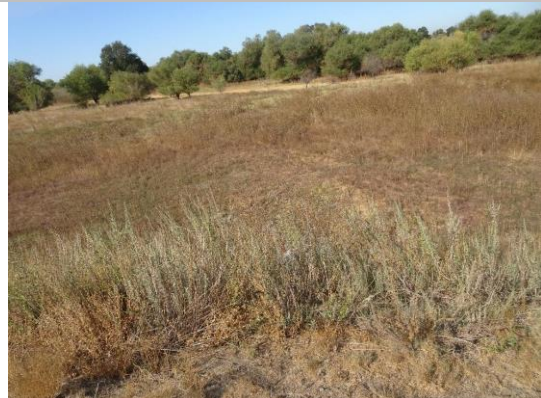
Photo 2 of 3 : UCIP_FA_2022_70689_90960.jpg

WS view: dense vegetation near WS toe.

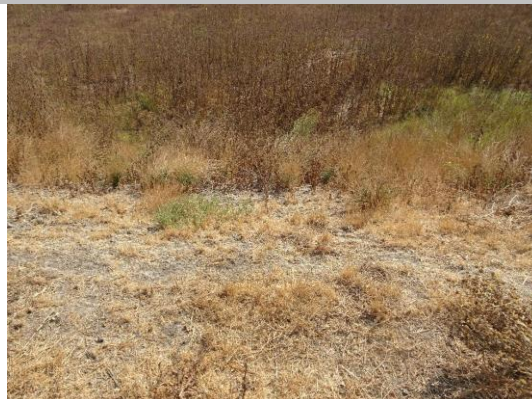
Photo 3 of 3 : UCIP_FA_2022_70689_90961.jpg

LS view: view of LS slope

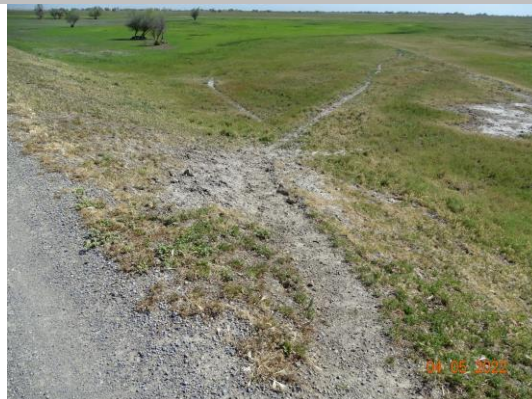
Photo 1 of 1 : FA_2022_NA0010_118_135_20220822_00023.jpg

LM Start	12.24	Rating **	A/W	Issue No.	135
LM End	12.24	Issue Type +	Ma	Location *	LS
Category	Earthen Levee			GPS Latitude/Longitude	
				Start	End
Item	Erosion / Livestock			37.263732 °	37.263732 °
				-120.827306 °	-120.827306 °
DWR ID	DWR_NA0010_01_s_2022_135				
Comment Code					
E4 : Repair the levee slope damaged by livestock and prevent large animal access.					
Inspector Comment

Livestock caused erosion on the landside slope. (Spring 2022)

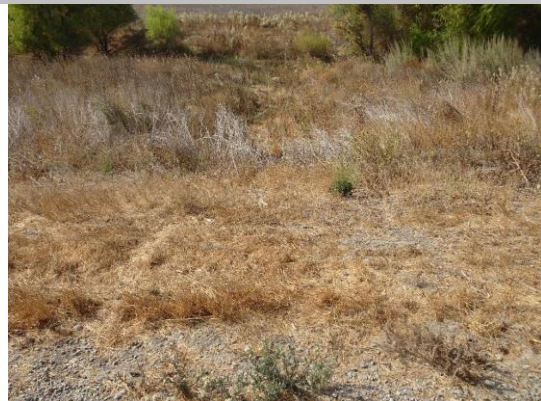
Photo 1 of 3 : UCIP_FA_2022_70690_90966.jpg

Comment Code						
Inspector Comment						
DS_ID:19637 FS_ID:70690 EP_NO: N/A Repair Type: Non-Urgent EVAL Issue: 5, Pipe Damage Crossing Status: Found UCIP Comments: 10/21/2020 Record remains Non-Urgent. DWR DMP has found integrity issues, LOF between 4 and 5. Crossing will be monitored until funding becomes available for rehabilitation. Proper inspection inhibited by dense vegetation. Recommend vegetation removal along pipe alignment. No permit was found authorizing this encroachment. CVFPB will need to review crossing to determine owner. (B. Singh - GEI, O. Magana - DWR UCIP)04/25/2014 Concrete headwall on landward side blocked by debris. Dense vegetation limits the inspector's visibility to identify signs of pipe failure (leaks) along the landward slope. Recommend removing vegetation along pipe alignment to conduct proper inspection of crossing. (O. Magana - DWR UCIP) FIELD_STRUCT_DESC: 24-inch corrugated metal (CM) gravity drainage pipe through the levee, 9.5 feet below the crown. Flap gate on the waterside (WS) end. Brass cap No. 60 bench mark (BM) on the headwall on the landside (LS). [Additional Reference(s): DWR Levee Log, 2002, (HLM 12.95). USACE San Joaquin O&M Manual, Unit No. 601, Part No. 1, (SJR601.1), 1967, Revised 25 May 2011, (HLM 12.94)]. FS Date: 10/21/2020

WS view: dense vegetation along WS toe. Pipe and flap gate visible on WS toe.

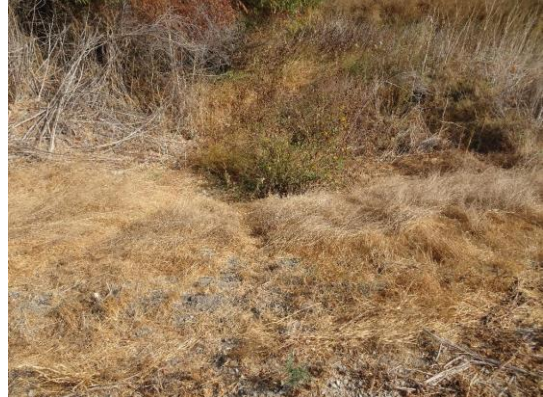
Photo 2 of 3 : UCIP_FA_2022_70690_90964.jpg

LS view: dense vegetation along LS toe. No pipe visible.

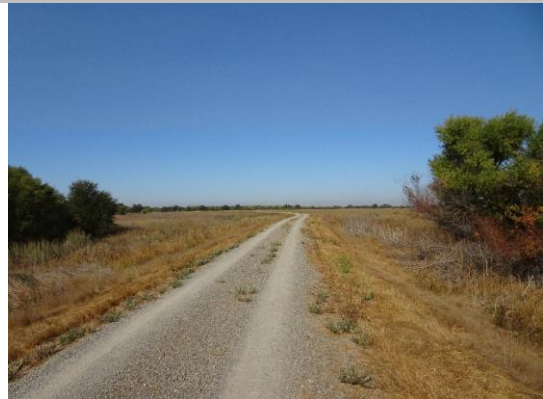
Photo 3 of 3 : UCIP_FA_2022_70690_90962.jpg

Overview of levee crown looking downstream towards pipe crossing.

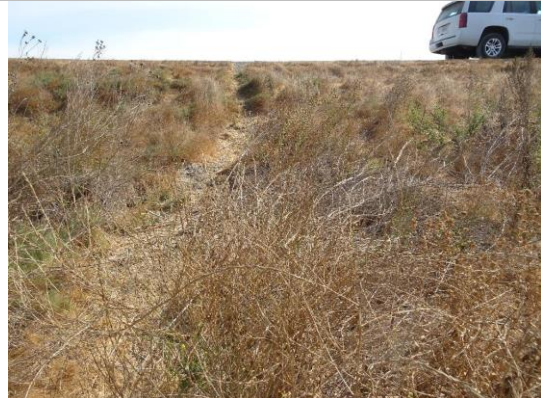
Photo 2 of 2 : UCIP_FA_2022_70691_90970.jpg

LS view: overview of LS slope

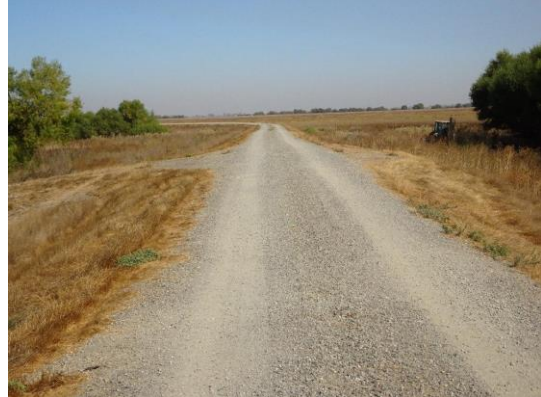
Photo 1 of 3 : UCIP_FA_2022_70692_90971.jpg

Comment Code						
Inspector Comment						
DS_ID:19639 FS_ID:70692 EP_NO: N/A Repair Type: Non-Urgent EVAL Issue: Crossing Status: Found UCIP Comments: 10/21/2020 Record remains Non-Urgent. No permit was found authorizing this encroachment. CVFPB will need to review crossing to determine owner. DWR DMP internal inspection is pending and scheduled for 2021. (B. Singh - GEI, O. Magana - DWR UCIP)04/25/2014 No access to waterward toe due to fence. Unable to find the concrete headwall and flap gate on waterward side past fence. Also dense vegetation limits the inspector's visibility to identify signs of pipe failure (leaks) along the waterward slope. Recommend removing vegetation along pipe alignment to conduct proper inspection of structure. Also need access past fence on waterward side. (O. Magana - DWR UCIP) FIELD_STRUCT_DESC: 24-inch corrugated metal (CM) gravity drainage pipe through the levee, 14.5 feet below the crown. Flap gate on the waterside (WS) end. Brass cap No. 60 bench mark (BM) on the headwall on the landside (LS). [Additional Reference(s): DWR Levee Log, 2002, (HLM 13.58). USACE San Joaquin O&M Manual, Unit No. 601, Part No. 1, (SJR601.1), 1967, Revised 25 May 2011, (HLM 13.58)]. FS Date: 10/21/2020

Overview of levee crown looking downstream towards crossing.

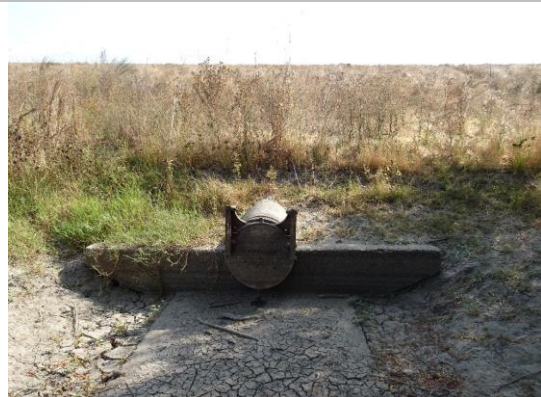
Photo 2 of 3 : UCIP_FA_2022_70692_90974.jpg

WS view: pipe, headwall, and flapgate at WS toe

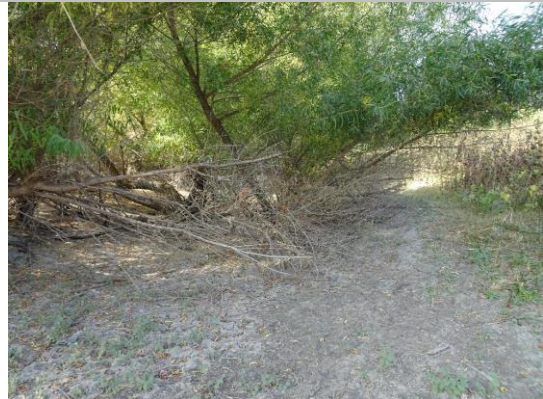
Photo 3 of 3 : UCIP_FA_2022_70692_90975.jpg

WS view: overview looking towards drainage past pipe outlet.

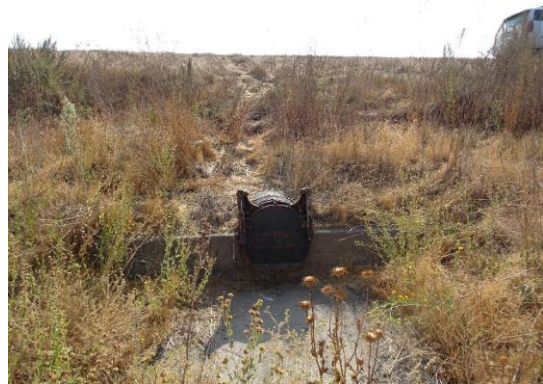
Photo 1 of 3 : UCIP_FA_2022_70693_90984.jpg

DS_ID:19640
 FS_ID:70693
 EP_NO: N/A
 Repair Type: Non-Urgent
 EVAL Issue:
 Crossing Status: Indicator Found
 UCIP Comments: 10/21/2020 Record remains Non-Urgent. No permit was found authorizing this encroachment. CVFPB will need to review crossing to determine owner. DWR DMP has not found internal issues, LOF between 1 and 2. Recommend inspection in 5 years. (B. Singh - GEI, O. Magana - DWR UCIP)04/25/2014 No photos available-- missed crossing. Aerial photograph indicates crossing is present. Need to confirm if crossing is still present on waterward side. (O. Magana - DWR UCIP)
 FIELD_STRUCT_DESC: 24-inch corrugated metal (CM) gravity drainage pipe through the levee, 11.0 feet below the crown. Flap gate on the waterside (WS) end. Brass cap No. 60 bench mark (BM) on the headwall on the landside (LS). [Additional Reference(s): DWR Levee Log, 2002, (HLM 13.83). USACE San Joaquin O&M Manual, Unit No. 601, Part No. 1, (SJR601.1), 1967, Revised 25 May 2011, (HLM 13.81)].

WS view: Pipe, flapgate, and headwall at WS toe

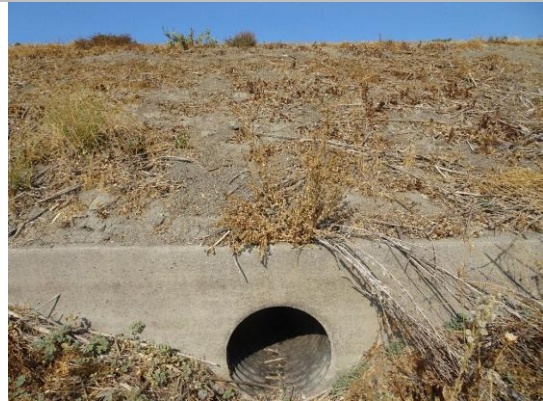
Photo 2 of 3 : UCIP_FA_2022_70693_90982.jpg

LS view: Pipe and headwall at LS toe

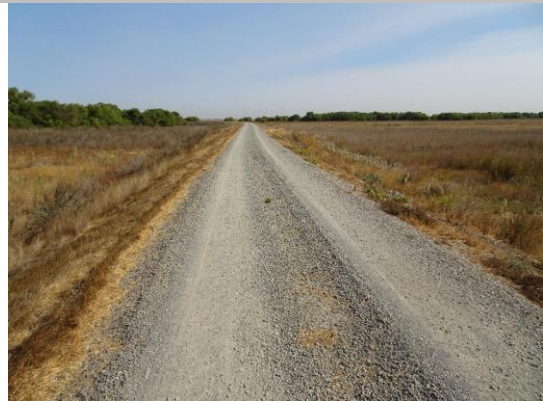
Photo 3 of 3 : UCIP_FA_2022_70693_90977.jpg

Overview of levee crown looking downstream towards crossing.

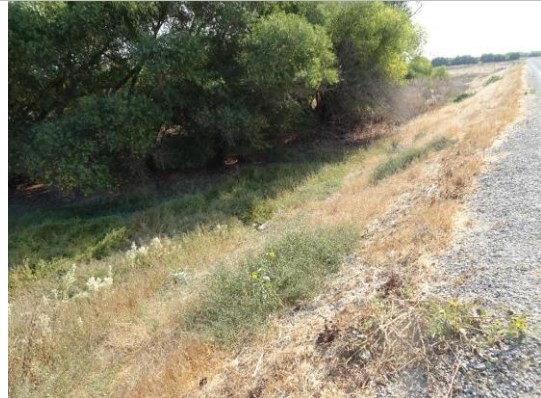
Photo 2 of 3 : UCIP_FA_2022_70694_90988.jpg

LS view: overview of LS

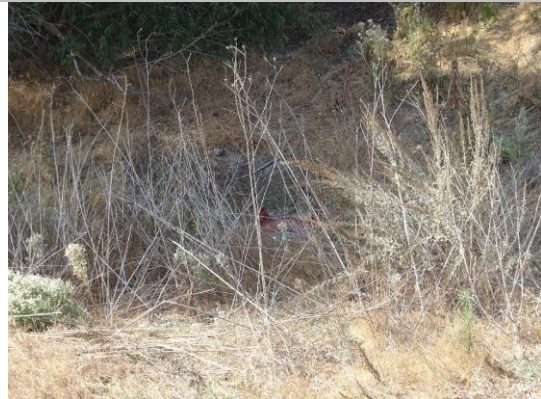
Photo 3 of 3 : UCIP_FA_2022_70694_90985.jpg

WS view: Pipe and flapgate visible through dense vegetation

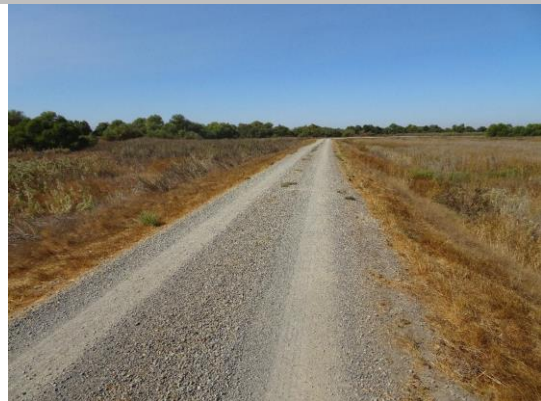
Photo 1 of 3 : UCIP_FA_2022_70695_90992.jpg

DS_ID:19642
 FS_ID:70695
 EP_NO: N/A
 Repair Type: Non-Urgent
 EVAL Issue:
 Crossing Status: Found
 UCIP Comments: 10/21/2020 Record remains Non-Urgent. Dense vegetation along the pipe alignment prevented proper inspection of the levee and pipe. No permit was found authorizing this encroachment. CVFPB will need to review crossing to determine owner. DWR DMP has not found internal issues, LOF between 1 and 2. Recommend inspection in 5 years. (B. Singh - GEI, O. Magana - DWR UCIP)04/25/2014 Dense vegetation limits the inspector's visibility to identify signs of pipe failure (leaks) along the landward slope and toe. Recommend removing vegetation along pipe alignment to conduct proper inspection of structure. (O. Magana - DWR UCIP)
 FIELD_STRUCT_DESC: 24-inch corrugated metal (CM) gravity drainage pipe through the levee, 9.7 feet below the crown. Flap gate on the waterside (WS) end. Brass cap No. 60 bench mark (BM) on the headwall on the landside (LS). [Additional Reference(s): DWR Levee Log, 2002, (HLM 14.65). USACE San Joaquin O&M Manual, Unit No. 601, Part No. 1, (SJR601.1), 1967, Revised 25 May 2011, (HLM 14.65)].

Overview of levee crown looking downstream toward crossing.

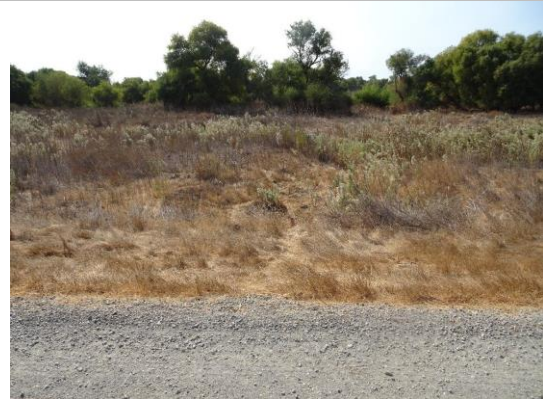
Photo 3 of 3 : UCIP_FA_2022_70695_90997.jpg

WS view: overview of WS

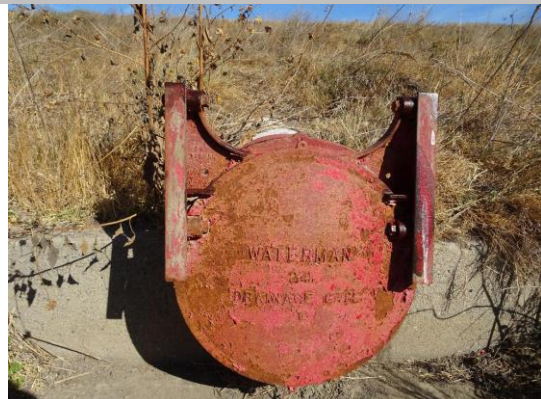
Photo 2 of 3 : UCIP_FA_2022_70696_90794.jpg

WS view: close-up view of pipe, flapgate, and headwall at WS toe

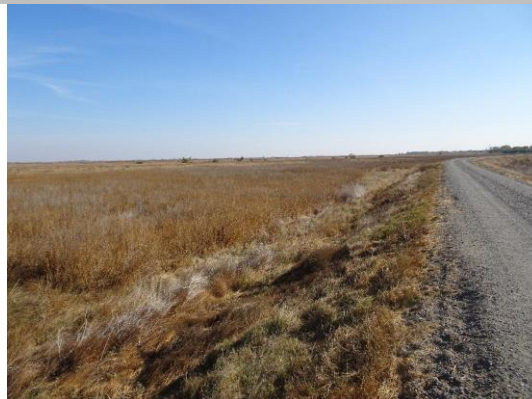
Photo 3 of 3 : UCIP_FA_2022_70696_92867.jpg

LS view: profile view of LS slope

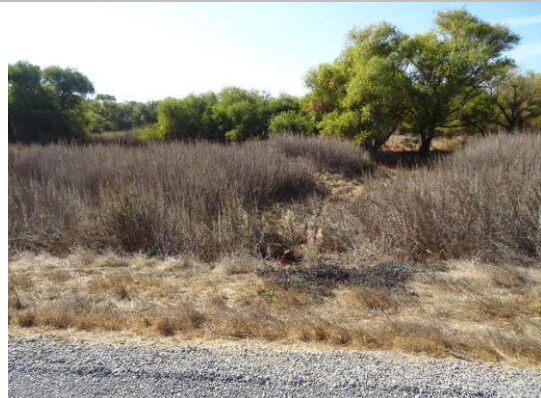
Photo 2 of 3 : UCIP_FA_2022_70697_90798.jpg

WS view: overview of WS. Pipe and flapgate visible at WS toe.

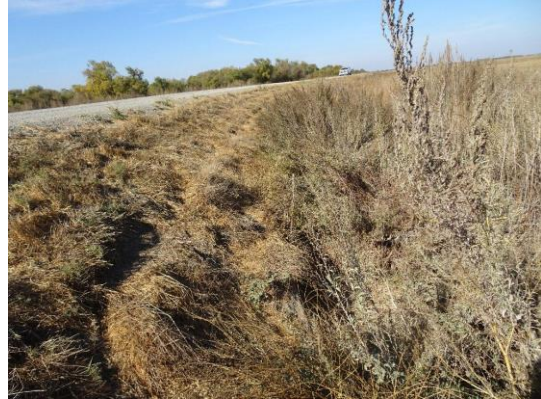
Photo 3 of 3 : UCIP_FA_2022_70697_90799.jpg

LS view: Headwall at LS toe. Dense vegetation inhibited proper inspection of pipe.

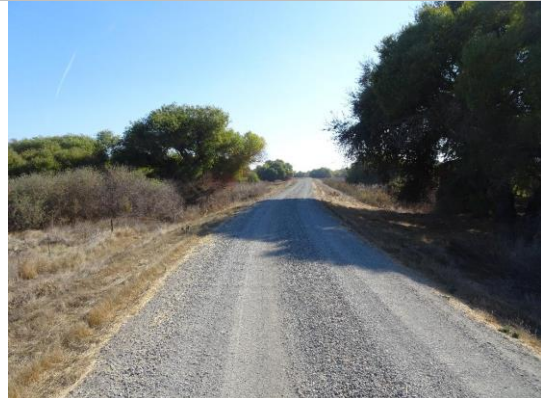
Photo 1 of 3 : UCIP_FA_2022_70698_90803.jpg

Overview of levee crown, looking US

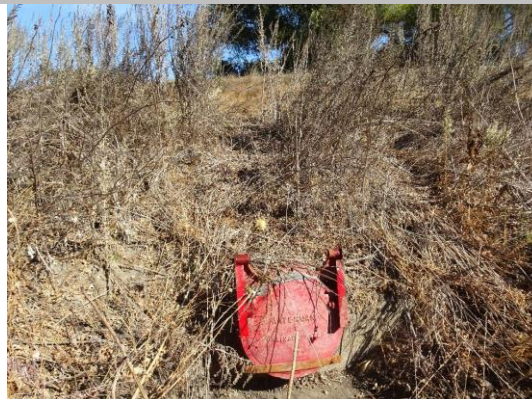
Photo 2 of 3 : UCIP_FA_2022_70698_90806.jpg

WS view: pipe, flapgate, and headwall at WS toe

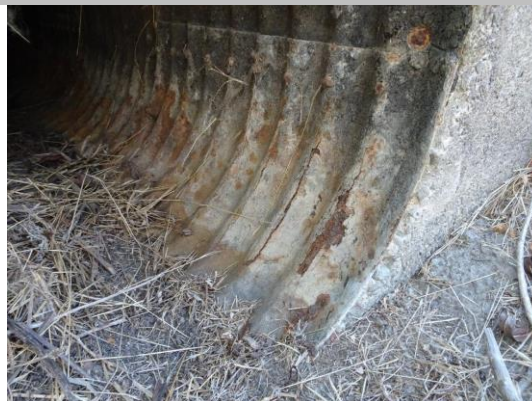
Photo 3 of 3 : UCIP_FA_2022_70698_90801.jpg

DS_ID:19645
FS_ID:70698
EP_NO: N/A
Repair Type: Non-Urgent
EVAL Issue:
Crossing Status: Found
UCIP Comments: 11/16/2020 Record remains Non-Urgent. Corrosion observed in pipe inlet on the LS toe. Recommend internal inspection of the pipe through the levee to determine extent of damage. Some burrowing activity found on both LS and WS slope. No permit was found authorizing this encroachment. CVFPB will need to review crossing to determine owner. DWR DMP internal inspection is pending and scheduled for 2021. (B. Singh - GEI, O. Magana - DWR UCIP)04/25/2014 Dense vegetation limits the inspector's visibility to identify signs of pipe failure (leaks) along the waterward and landward slope. Recommend removing vegetation along pipe alignment to conduct proper inspection of structure. (O. Magana - DWR UCIP) FIELD_STRUCT_DESC: 24-inch corrugated metal (CM) gravity drainage pipe through the levee, 11.0 feet below the crown. Flap gate on the waterside (WS) end. Brass cap No. 60 bench mark (BM) on the headwall on the landside (LS). [Additional Reference(s): DWR Levee Log, 2002, (HLM 15.82). USACE San Joaquin O&M Manual, Unit No. 601, Part No. 1, (SJR601.1), 1967, Revised 25 May 2011, (HLM 15.81)]. FS Date: 11/16/2020

LS view: pipe corrosion visible at invert of pipe at LS toe

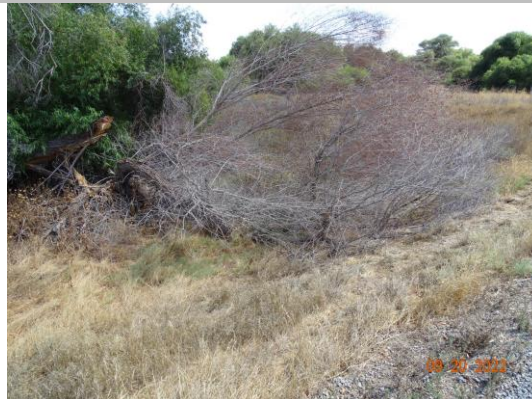
Photo 1 of 1 : FA_2022_NA0010_118_144_20221007_00299.jpg

LM Start	15.83	Rating **	M	Issue No.	144
LM End	15.83	Issue Type +	Ma	Location *	LS
Category	Earthen Levee			GPS Latitude/Longitude	
				Start	End
Item	Trim / Thin Trees			37.226023 °	37.226023 °
				-120.799043 °	-120.799043 °
DWR ID	DWR_NA0010_01_f_2022_144				
Comment Code					
T2 : Tree or limb.					
Inspector Comment

View of dead tree fallen on the landside toe and slope. (Fall 2022)

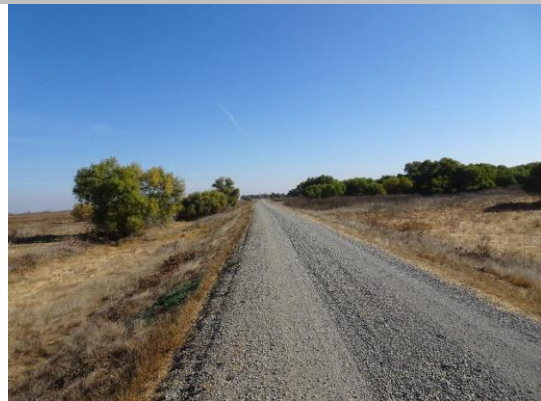
Photo 1 of 3 : UCIP_FA_2022_70699_92966.jpg

Comment Code					
Inspector Comment					
DS_ID:19646 FS_ID:70699 EP_NO: N/A Repair Type: Urgent EVAL Issue: 1, Pipe Integrity Crossing Status: Found UCIP Comments: 11/16/2020 Record has been updated from Non-Urgent to Urgent. DWR DMP has found integrity issues, LOF between 5 and 6. Crossing will be monitored until funding becomes available to address. Burrowing activity observed on LS and WS slopes. No permit was found authorizing this encroachment. CVFPB will need to review crossing to determine owner. (B. Singh - GEI, O. Magana - DWR UCIP)04/25/2014 Dense vegetation limits the inspector's visibility to identify signs of pipe failure (leaks) along the waterward and landward slopes. Recommend removing vegetation along pipe alignment to conduct proper inspection of structure and appurtenances. (O. Magana - DWR UCIP) FIELD_STRUCT_DESC: 24-inch corrugated metal (CM) gravity drainage pipe through the levee, 11.3 feet below the crown. Flap gate on the waterside (WS) end. Brass cap No. 50 bench mark (BM) on the headwall on the landside (LS). [Additional Reference(s): DWR Levee Log, 2002, (HLM 16.09). USACE San Joaquin O&M Manual, Unit No. 601, Part No. 1, (SJR601.1), 1967, Revised 25 May 2011, (HLM 16.09)]. FS Date: 11/16/2020

Overview of levee looking upstream towards crossing.

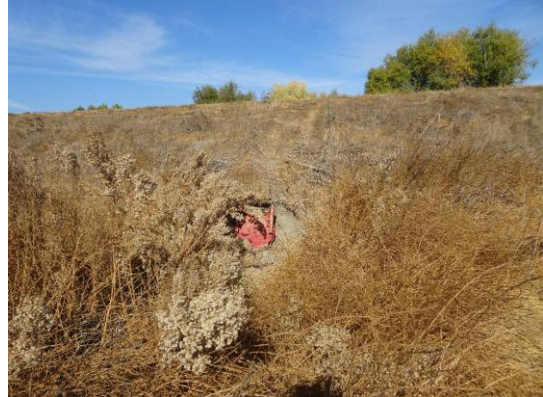
Photo 2 of 3 : UCIP_FA_2022_70699_92965.jpg

WS view: concrete wingwall and pipe with flap gate visible on WS toe.

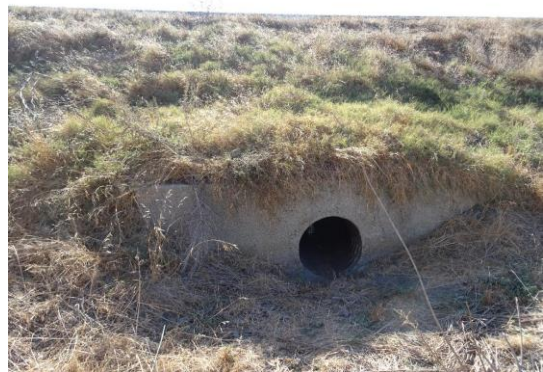
Photo 3 of 3 : UCIP_FA_2022_70699_92964.jpg

LS view: concrete headwall with pipe inlet visible on LS toe.

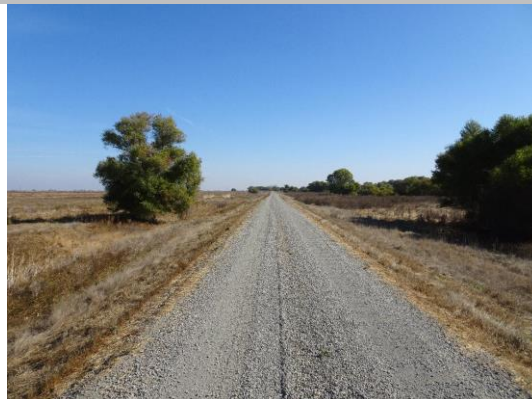
Photo 1 of 3 : UCIP_FA_2022_70700_92979.jpg

DS_ID:19647
FS_ID:70700
EP_NO: N/A
Repair Type: Non-Urgent
EVAL Issue:
Crossing Status: Found
UCIP Comments: 11/16/2020 Record remains Non-Urgent. Pipe and flapgate on WS toe were under water and there is dense vegetation on the LS slope and toe, inhibiting inspection. No permit was found authorizing this encroachment. CVFPB will need to review crossing to determine owner. DWR DMP internal inspection status is pending. Contacted A. Asrate with DMP staff to find out internal inspection results from 2020. (B. Singh - GEI, O. Magana - DWR UCIP)04/25/2014 Dense vegetation limits the inspector's visibility to identify signs of pipe failure (leaks) along the waterward and landward slopes. Recommend removing vegetation along pipe alignment to conduct proper inspection of structure. Unable to find pipe on landward side. (O. Magana - DWR UCIP)
FIELD_STRUCT_DESC: 24-inch corrugated metal (CM) gravity drainage pipe through the levee, 14.7 feet below the crown. Flap gate on the waterside (WS) end. Brass cap No. 50 bench mark (BM) on the headwall on the landside (LS). [Additional Reference(s): DWR Levee Log, 2002, (HLM 16.16). USACE San Joaquin O&M Manual, Unit No. 601, Part No. 1, (SJR601.1), 1967, Revised 25 May 2011, (HLM 16.15)].

Overview of levee crown looking upstream towards pipe crossing.

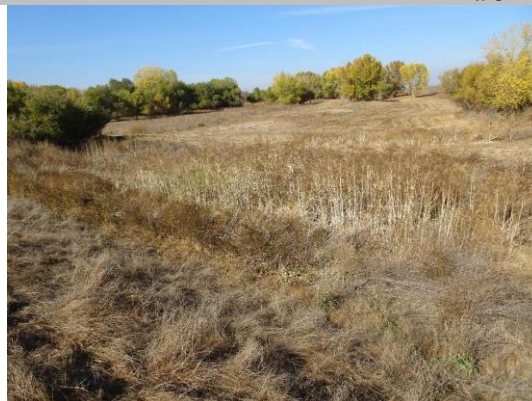
Photo 2 of 3 : UCIP_FA_2022_70700_92980.jpg

LS view: overview of LS.

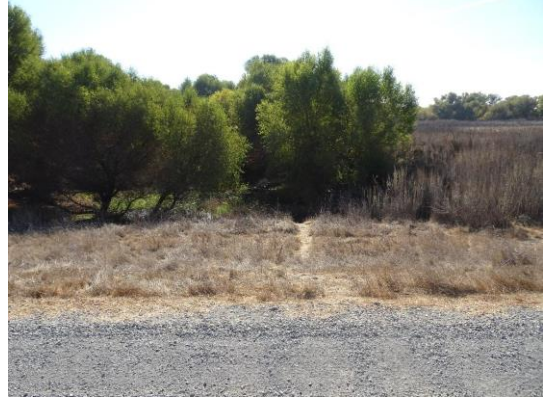
Photo 3 of 3 : UCIP_FA_2022_70700_92978.jpg

WS view: overview of WS.

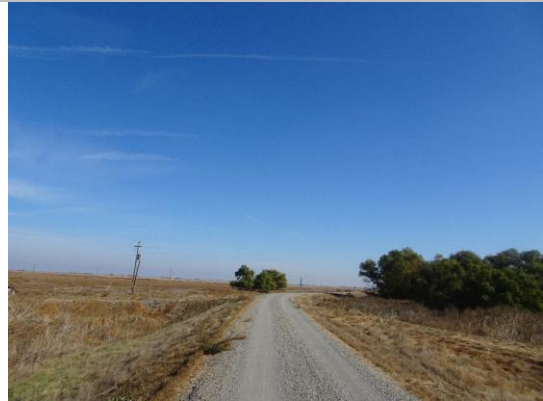
Photo 1 of 3 : UCIP_FA_2022_70701_90813.jpg

DS_ID:19649
 FS_ID:70701
 EP_NO: 13549
 Repair Type: Non-Urgent
 EVAL Issue: 10, Unauthorized Modification or Non-Compliant Permit
 Crossing Status: Not Found
 UCIP Comments: 11/16/2020 Record remains Non-Urgent. Gravity drainage pipe through the levee, 2 feet below the crown, was measured at 12 inches instead of 30 inches pipe. Pump and concrete standpipe at the center of the levee were not found, and a siphon breaker was not found on the LS shoulder. Recommend a detail review of permit and record files to determine what was constructed at this location and the alignment of the pipe. Need to contact owner to obtain permit authorizing modifications to previously approved 30-inch pipe. (B. Singh - GEI, O. Magana - DWR UCIP)
 FIELD_STRUCT_DESC: 30-inch coated steel irrigation discharge pipe through the levee, 2.0 feet below the crown. Steel cutoff walls around the pipe at the center of the levee. Siphon breaker on the apex of the pipe on the landside (LS) shoulder. Pump and concrete standpipe on the waterside (WS). Pipe extends to existing irrigation ditch off the LS toe. (Concrete irrigation pipe stand, 60-horsepower [hp] pump, 30-inch steel pipe, and enlarged diversion channel from the river to the pump intake authorized under Permit No. 13549, 1983 - Joseph E. Gallo).

Overview of levee crown, looking US

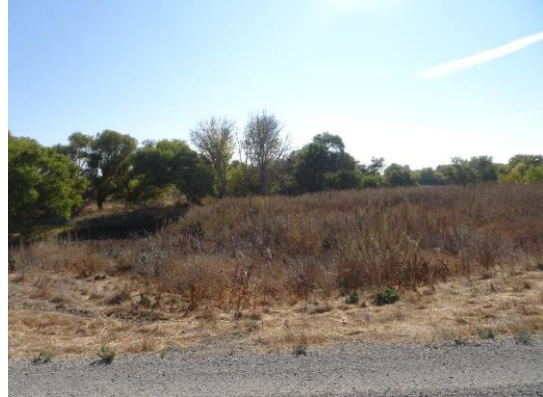
Photo 2 of 3 : UCIP_FA_2022_70701_90814.jpg

WS view: overview of WS. Pipe not found at WS toe and dense vegetation.

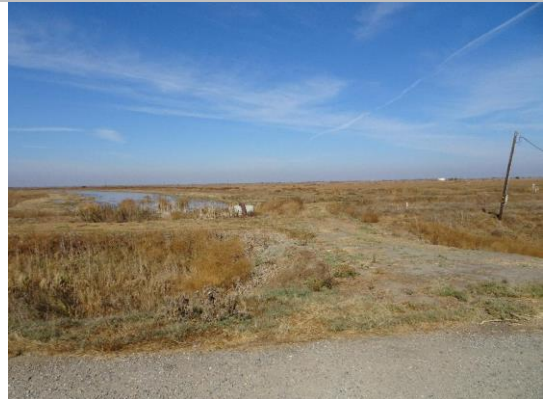
Photo 3 of 3 : UCIP_FA_2022_70701_90815.jpg

LS view: overview of LS. Concrete cone with 12" pipe found.

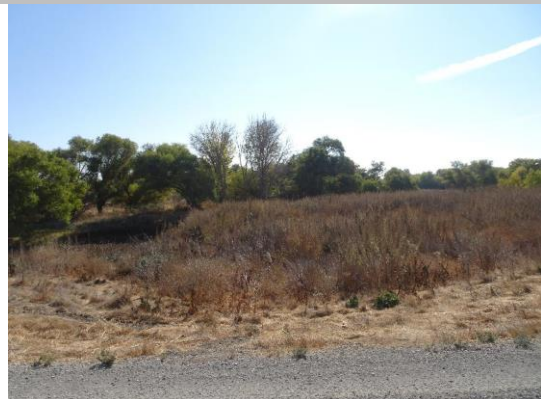
Photo 2 of 3 : UCIP_FA_2022_70703_90821.jpg

WS view: overview of WS. Pipe and flapgate not found; dense vegetation.

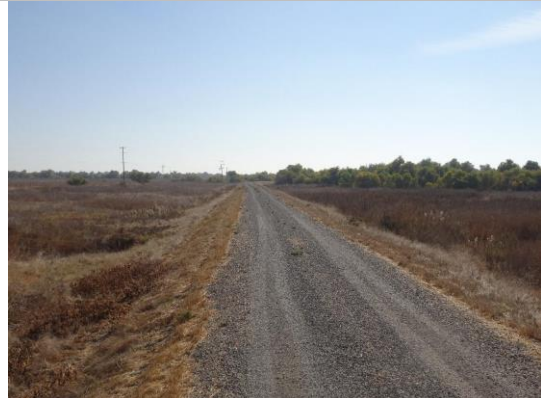
Photo 1 of 3 : UCIP_FA_2022_70704_90825.jpg

DS_ID:19577
 FS_ID:70704
 EP_NO: N/A
 Repair Type: Non-Urgent
 EVAL Issue:
 Crossing Status: Found
 UCIP Comments: 11/16/2020 Record remains Non-Urgent. No permit was found authorizing this encroachment. CVFPB will need to review crossing to determine owner. DWR DMP has not found internal issues, LOF between 1 and 2. Recommend inspection in 5 years. (B. Singh - GEI, O. Magana - DWR UCIP)04/25/2014 Dense vegetation limits the inspector's visibility to identify signs of pipe failure (leaks) along the waterward and landward slopes. Concrete headwall is buried by dense vegetation. Recommend removing vegetation along pipe alignment to conduct proper inspection of structure. (O. Magana - DWR UCIP)
 FIELD_STRUCT_DESC: 24-inch corrugated metal (CM) gravity drainage pipe through the levee, 11.5 feet below the crown. Flap gate on the waterside (WS) end. Brass cap No. 50 bench mark (BM) on the headwall on the landside (LS). [Additional Reference(s): DWR Levee Log, 2002, (HLM 17.01). USACE San Joaquin O&M Manual, Unit No. 601, Part No. 1, (SJR601.1), 1967, Revised 25 May 2011, (HLM 17.01)].

Overview of levee crown, looking US

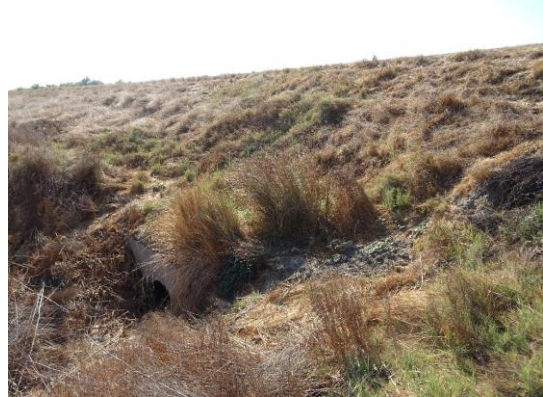
Photo 2 of 3 : UCIP_FA_2022_70704_90827.jpg

LS view: slope above pipe and headwall from LS toe

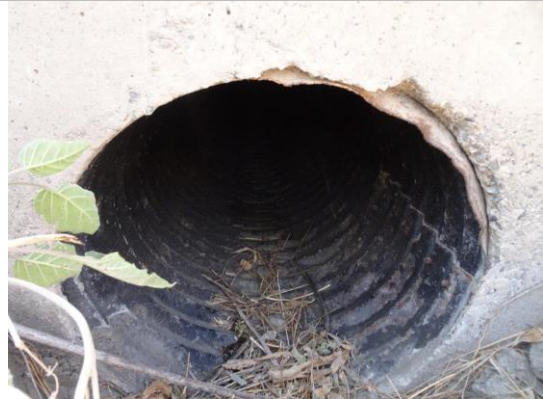
Photo 3 of 3 : UCIP_FA_2022_70704_90829.jpg

LS view: minor damage to headwall concrete at inlet on LS toe.

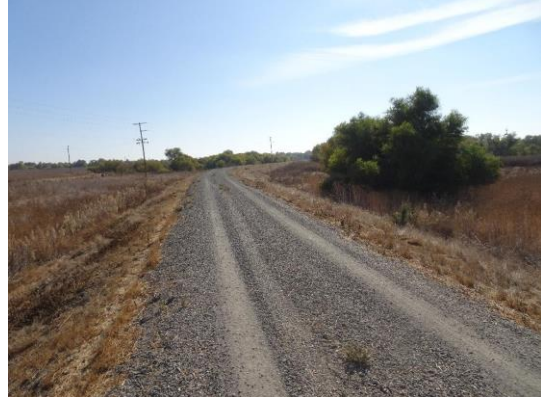
Photo 1 of 3 : UCIP_FA_2022_70705_93002.jpg

Comment Code					
Inspector Comment					
DS_ID:19578 FS_ID:70705 EP_NO: N/A Repair Type: Non-Urgent EVAL Issue: Crossing Status: Found UCIP Comments: 11/16/2020 Record remains Non-Urgent. No permit was found authorizing this encroachment. CVFPB will need to review crossing to determine owner. DWR DMP has not found internal issues, LOF between 1 and 2. Recommend inspection in 5 years. (B. Singh - GEI, O. Magana - DWR UCIP)04/25/2014 Dense vegetation limits the inspector's visibility to identify signs of pipe failure (leaks) along the waterward and landward slopes. Recommend removing vegetation along pipe alignment to conduct proper inspection of structure. Sediment buildup inside pipe visible from landward side. Recommend clearing pipe. (O. Magana - DWR UCIP) FIELD_STRUCT_DESC: 24-inch corrugated metal (CM) gravity drainage pipe through the levee, 11.5 feet below the crown. Flap gate on the waterside (WS) end. Brass cap No. 50 bench mark (BM) on the headwall on the landside (LS). [Additional Reference(s): DWR Levee Log, 2002, (HLM 17.20). USACE San Joaquin O&M Manual, Unit No. 601, Part No. 1, (SJR601.1), 1967, Revised 25 May 2011, (HLM 17.19)]. FS Date: 11/16/2020

Overview of levee crown looking upstream towards pipe crossing.

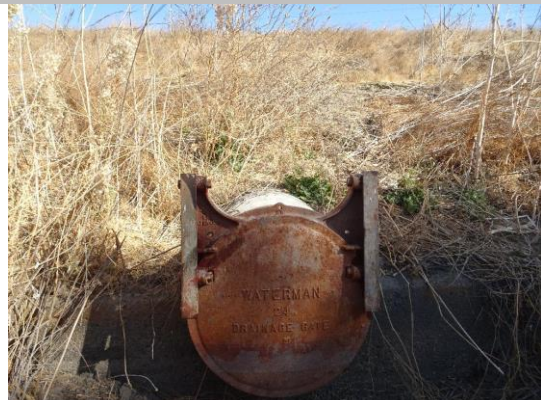
Photo 2 of 3 : UCIP_FA_2022_70705_93001.jpg

WS view: close up of flap gate, pipe, and concrete headwall.

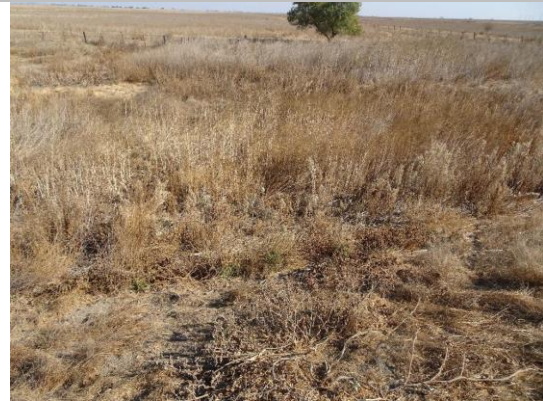
Photo 3 of 3 : UCIP_FA_2022_70705_93005.jpg

LS view: dense vegetation along LS toe.

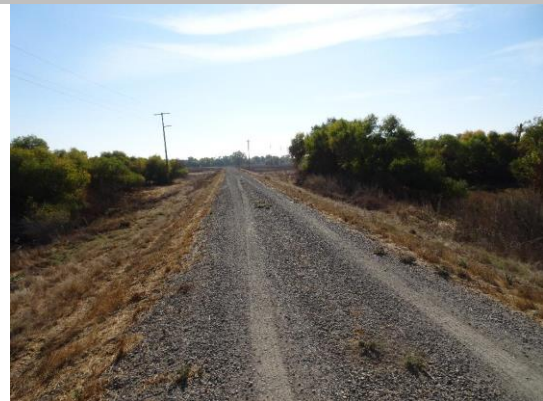
Photo 1 of 3 : UCIP_FA_2022_70706_90834.jpg

DS_ID:19579
 FS_ID:70706
 EP_NO: N/A
 Repair Type: Non-Urgent
 EVAL Issue:
 Crossing Status: Found
 UCIP Comments: 11/16/2020 Record remains Non-Urgent. Debris is blocking flapgate on the WS inlet. No permit was found authorizing this encroachment. CVFPB will need to review crossing to determine owner. DWR DMP internal inspection is pending and scheduled for 2021. (B. Singh - GEI, O. Magana - DWR UCIP)04/25/2014 Dense vegetation limits the inspector's visibility to identify signs of pipe failure (leaks) along the waterward and landward slope. Recommend removing vegetation along pipe alignment to conduct proper inspection of structure. (O. Magana - DWR UCIP)
 FIELD_STRUCT_DESC: 24-inch corrugated metal (CM) gravity drainage pipe through the levee, 15.8 feet below the crown. Flap gate on the waterside (WS) end. Brass cap No. 50 bench mark (BM) on the headwall on the landside (LS). [Additional Reference(s): DWR Levee Log, 2002, (HLM 17.27). USACE San Joaquin O&M Manual, Unit No. 601, Part No. 1, (SJR601.1), 1967, Revised 25 May 2011, (HLM 17.26)].

Overview of levee crown looking upstream towards crossing.

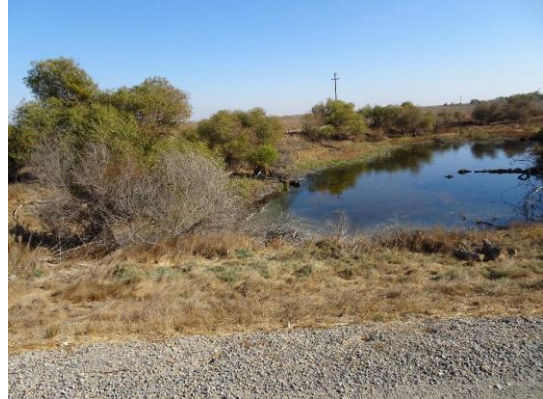
Photo 2 of 3 : UCIP_FA_2022_70706_90835.jpg

LS view: overview of LS

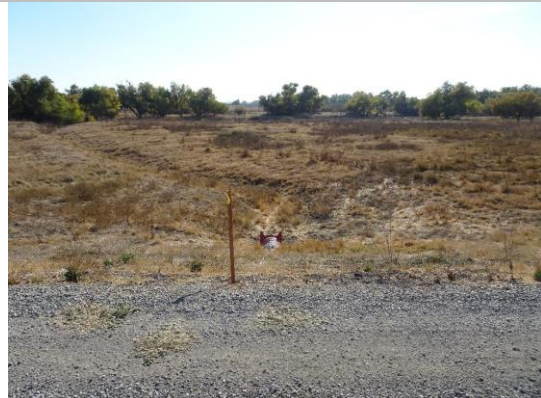
Photo 2 of 3 : UCIP_FA_2022_70707_90844.jpg

WS view: overview of WS. Pipe and flapgate visible on WS toe.

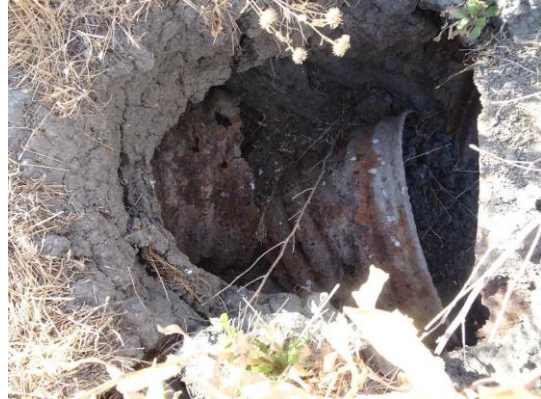
Photo 3 of 3 : UCIP_FA_2022_70707_90838.jpg

LS view: Pipe collapse visible in sinkhole along pipe alignment, photo 2 of 2.

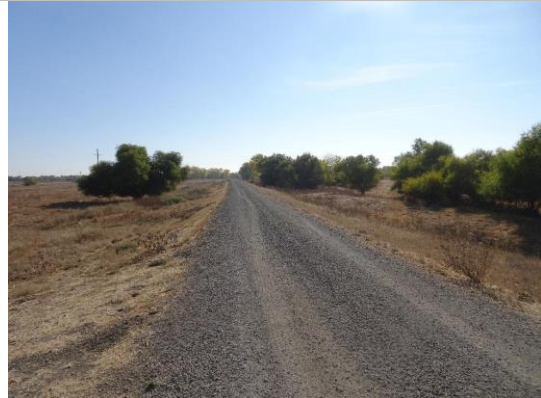
Photo 1 of 3 : UCIP_FA_2022_70708_90849.jpg

DS_ID:19581
FS_ID:70708
EP_NO: N/A
Repair Type: Urgent
EVAL Issue: 1, Pipe Integrity
Crossing Status: Found
UCIP Comments: 11/16/2020 Record has been updated from Non-Urgent to Urgent. Considerable damage to the pipe interior is visible from LS toe. DWR DMP has found integrity issues, LOF between 5 and 6. Crossing will be monitored until funding becomes available to address. No permit was found authorizing this encroachment. CVFPB will need to review crossing to determine owner. (B. Singh - GEI, O. Magana - DWR UCIP)04/25/2014 Need to contact owner. Recommend investigating integrity of pipe wall through levee heavy corrosion visible from landward side. (O. Magana - DWR UCIP)
FIELD_STRUCT_DESC: 24-inch corrugated metal (CM) gravity drainage pipe through the levee, 11.5 feet below the crown. Flap gate on the waterside (WS) end. Brass cap No. 50 bench mark (BM) on the headwall on the landside (LS). [Additional Reference(s): DWR Levee Log, 2002, (HLM 18.21). USACE San Joaquin O&M Manual, Unit No. 601, Part No. 1, (SJR601.1), 1967, Revised 25 May 2011, (HLM 18.19)].

Overview of levee crown looking upstream, photo 1 of 2.

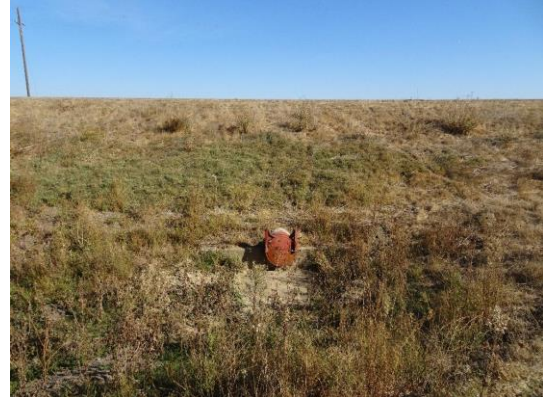
Photo 2 of 3 : UCIP_FA_2022_70708_90850.jpg

WS view: Pipe, flapgate, and headwall at WS toe

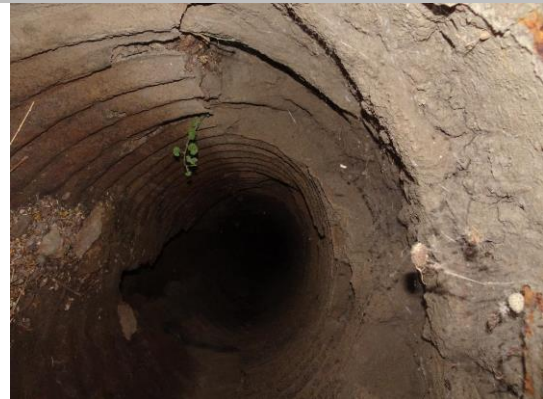
Photo 3 of 3 : UCIP_FA_2022_70708_90848.jpg

LS view: Considerable damage observed at LS inlet
