Flood Control Project Maintenance Levee Inspections

Fall 2022 Levee Maintenance Deficiency Summary Report

San Joaquin River Basin

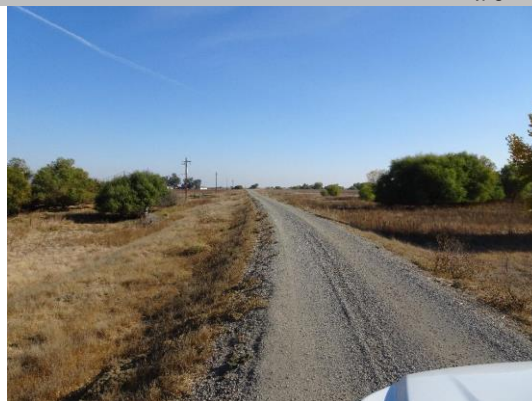
Photo 1 of 3 : UCIP_FA_2022_70709_93037.jpg

Comment Code						
Inspector Comment						
DS_ID:19582 FS_ID:70709 EP_NO: N/A Repair Type: Urgent EVAL Issue: 1, Pipe Integrity Crossing Status: Found UCIP Comments: 11/16/2020 Record has been updated from No Action Needed to Urgent. DWR DMP has found integrity issues, LOF between 5 and 6. No damage observed on the levee during the field inspection. Crossing will be monitored until funding becomes available to address. No permit was found authorizing this encroachment. CVFPB will need to review crossing to determine owner. (B. Singh - GEI, O. Magana - DWR UCIP) FIELD_STRUCT_DESC: 24-inch corrugated metal (CM) gravity drainage pipe through the levee, 9.4 feet below the crown. Flap gate on the waterside (WS) end. Brass cap No. 50 bench mark (BM) on the headwall on the landside (LS). [Additional Reference(s): DWR Levee Log, 2002, (HLM 18.47). USACE San Joaquin O&M Manual, Unit No. 601, Part No. 1, (SJR601.1), 1967, Revised 25 May 2011, (HLM 18.45)]. FS Date: 11/16/2020

Overview of levee crown looking upstream, photo 1 of 2.

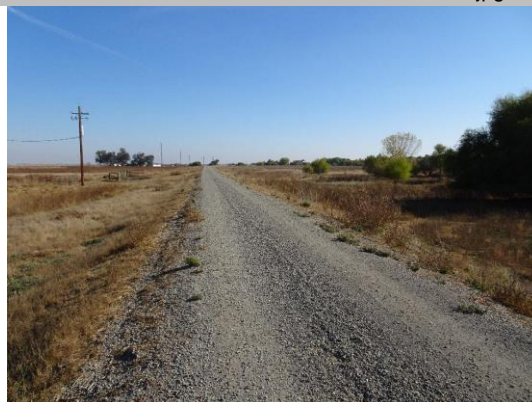
Photo 2 of 3 : UCIP_FA_2022_70709_90856.jpg

Overview of levee crown looking upstream, photo 2 of 2.

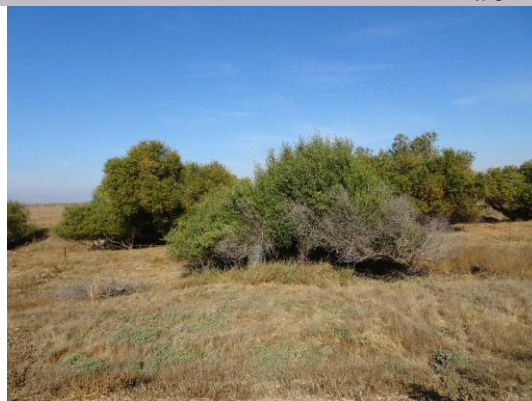
Photo 3 of 3 : UCIP_FA_2022_70709_90854.jpg

LS view: overview of LS.

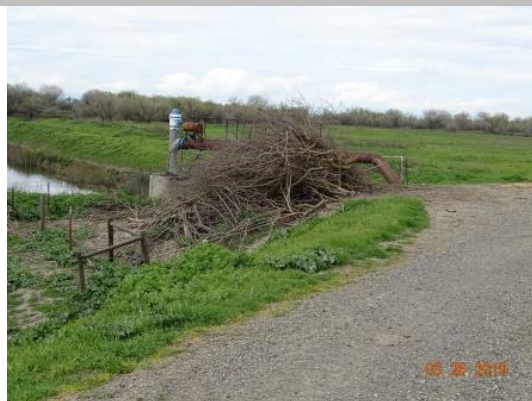
Photo 1 of 1 : FA_2022_NA0010_118_134_20220822_00022.jpg

LM Start	18.77	Rating **	U	Issue No.	134
LM End	18.77	Issue Type +	En	Location *	WS
Category	Earthen Levee			GPS Latitude/Longitude	
				Start	End
Item	Encroachments			37.205064 °	37.205064 °
				-120.762721 °	-120.762721 °
DWR ID	DWR_NA0010_01_s_2019_134				
Comment Code					
PR : Prunings					
Inspector Comment

View of prunings on waterside slope. (Spring 2019)

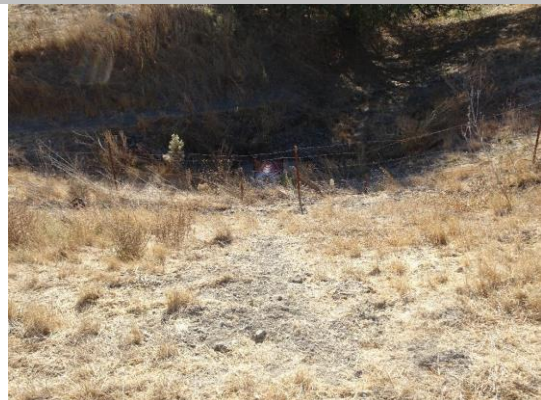
Photo 2 of 3 : UCIP_FA_2022_70711_91061.jpg

View waterward

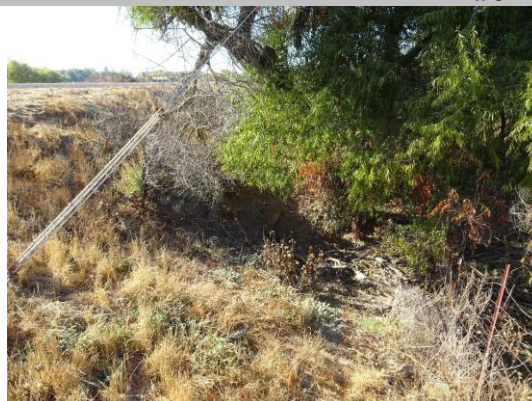
Photo 3 of 3 : UCIP_FA_2022_70711_91062.jpg

Headwall and pipe at LS toe

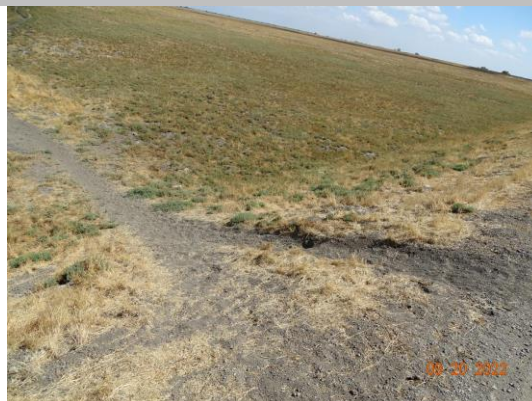
Photo 1 of 1 : FA_2022_NA0010_118_145_20221007_00300.jpg

View of livestock trail on the landside slope.

LM Start	18.85	Rating **	A/W	Issue No.	145
LM End	18.85	Issue Type +	Ma	Location *	LS
Category	Earthen Levee			GPS Latitude/Longitude	
				Start	End
Item	Erosion / Livestock			37.204414 °	37.204414 °
				-120.761543 °	-120.761543 °
DWR ID	DWR_NA0010_01_f_2022_145				
Comment Code					
E4 : Repair the levee slope damaged by livestock and prevent large animal access.					
Inspector Comment

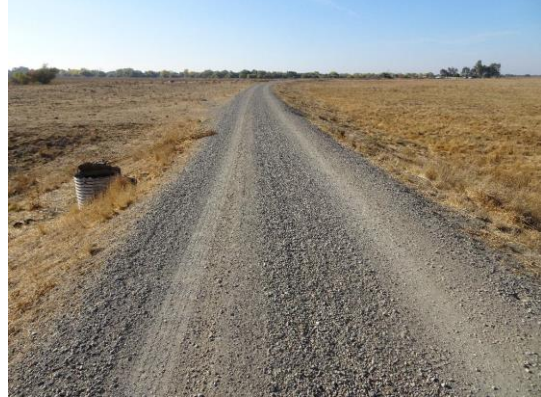
Photo 1 of 3 : UCIP_FA_2022_70712_90861.jpg

DS_ID:19594
FS_ID:70712
EP_NO: N/A
Repair Type: Non-Urgent
EVAL Issue: 11, Maintenance Compliance Issue
Crossing Status: Found
UCIP Comments: 11/16/2020 Record remains Non-Urgent. Unable to locate pipe on the WS. Pipe appears to be buried on WS. Sediment build-up observed at the LS inlet. Recommend sediment removal and evaluation of pipe's purpose. Pipe is currently non-functional. No permit was found authorizing this encroachment. CVFPB will need to review crossing to determine owner. DWR DMP internal inspection is pending and scheduled for 2021. Recommend adding riser cover on the WS as a safety measure. (B. Singh - GEI, O. Magana - DWR UCIP)04/25/2014 Non-functional crossing--pipe is buried on waterward side. Sediment buildup in pipe visible from landward side. Need to coordinate with owner to determine status. If crossing is no longer in use, owner will need to coordinate with DWR Inspector and CVFPB to properly abandon. (O. Magana - DWR UCIP)

Overview of levee crown

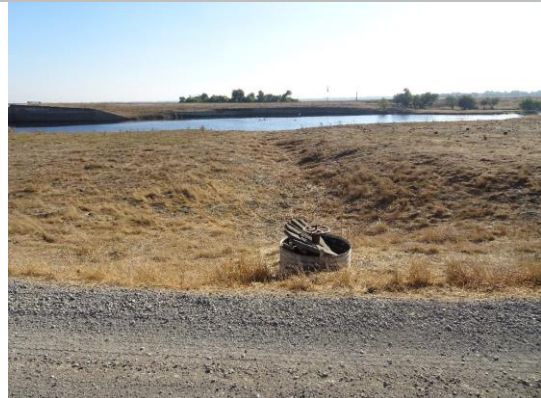
Photo 2 of 3 : UCIP_FA_2022_70712_90862.jpg

Pipe riser visible on WS slope

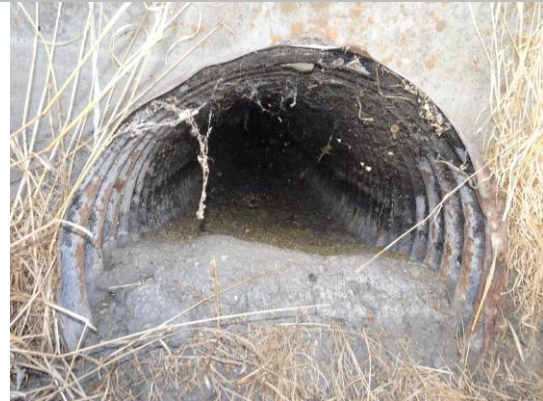
Photo 3 of 3 : UCIP_FA_2022_70712_90857.jpg

Considerable sediment build-up at LS inlet

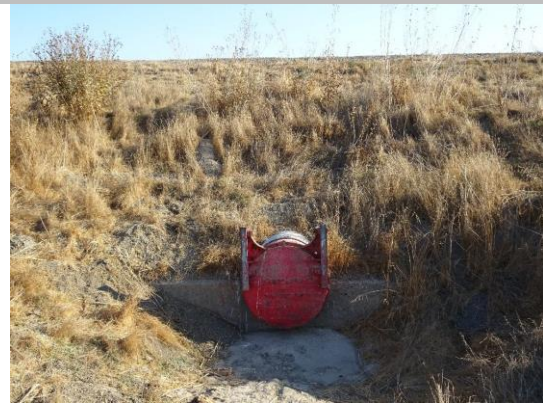
Photo 1 of 2 : UCIP_FA_2022_70716_90889.jpg

DS_ID:19596
 FS_ID:70716
 EP_NO: N/A
 Repair Type: Non-Urgent
 EVAL Issue:
 Crossing Status: Found
 UCIP Comments: 11/16/2020 Record remains Non-Urgent. No permit was found authorizing this encroachment. CVFPB will need to review crossing to determine owner. DWR DMP has not found internal issues, LOF between 1 and 2. Recommend inspection in 5 years. (B. Singh - GEI, O. Magana - DWR UCIP)04/25/2014 Dense vegetation limits the inspector's visibility to identify signs of pipe failure (leaks) along the waterward slope. Recommend removing vegetation along pipe alignment to conduct proper inspection of structure. Dense vegetation blocks both waterward and landward headwalls. Sediment buildup in pipe visible from landward side. (O. Magana - DWR UCIP)
 FIELD_STRUCT_DESC: 24-inch corrugated metal (CM) gravity drainage pipe through the levee, 8.0 feet below the crown. Flap gate on the waterside (WS) end. Brass cap No. 40 bench mark (BM) on the headwall on the landside (LS). [Additional Reference(s): DWR Levee Log, 2002, (HLM 19.54). USACE San Joaquin O&M Manual, Unit No. 601, Part No. 1, (SJR601.1), 1967, Revised 25 May 2011, (HLM 19.54)].

WS view: concrete headwall, flap gate, and WS slope visible on WS.

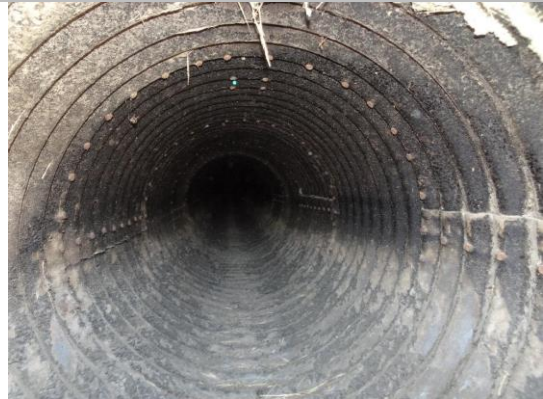
Photo 2 of 2 : UCIP_FA_2022_70716_90894.jpg

LS view: Interior of pipe from LS toe

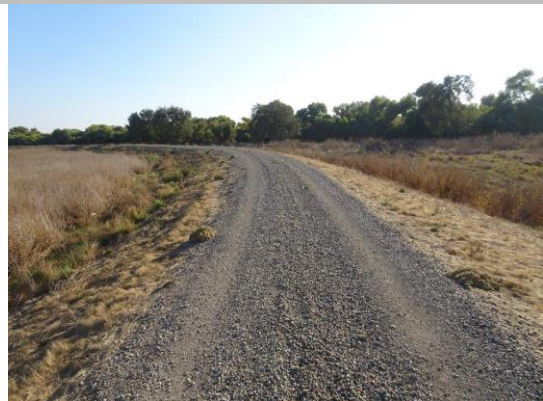
Photo 1 of 3 : UCIP_FA_2022_70717_90896.jpg

DS_ID:19597
 FS_ID:70717
 EP_NO: N/A
 Repair Type: Non-Urgent
 EVAL Issue:
 Crossing Status: Indicator Found
 UCIP Comments: 11/16/2020 Record remains Non-Urgent. No permit was found authorizing this encroachment. CVFPB will need to review crossing to determine owner. DWR DMP internal inspection is pending and scheduled for 2021. (B. Singh - GEI, O. Magana - DWR UCIP)04/25/2014 No photos available for crossing--crossing missed. Recommend taking photos to confirm status of crossing. (O. Magana - DWR UCIP)
 FIELD_STRUCT_DESC: 24-inch corrugated metal (CM) gravity drainage pipe through the levee, 8.0 feet below the crown. Flap gate on the waterside (WS) end. Brass cap No. 40 bench mark (BM) on the headwall on the landside (LS). [Additional Reference(s): DWR Levee Log, 2002, (HLM 19.82). USACE San Joaquin O&M Manual, Unit No. 601, Part No. 1, (SJR601.1), 1967, Revised 25 May 2011, (HLM 19.81)].
 FS Date: 11/16/2020

Overview of levee crown looking u/s

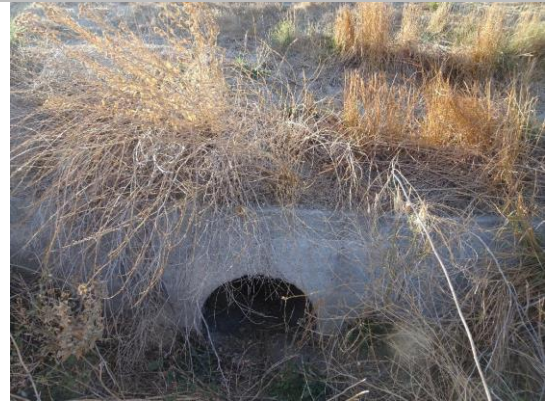
Photo 2 of 3 : UCIP_FA_2022_70717_90899.jpg

LS view: pipe and headwall at LS toe

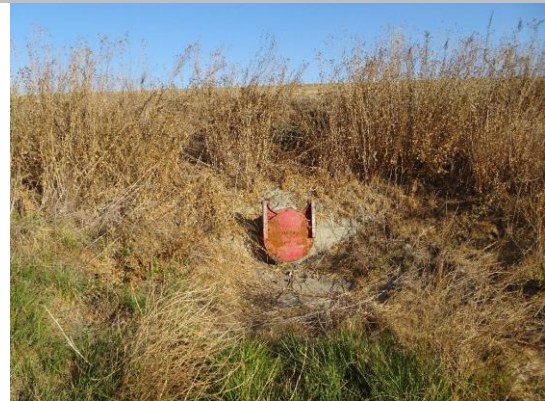
Photo 3 of 3 : UCIP_FA_2022_70717_90902.jpg

WS view: Pipe, flapgate, and headwall at WS toe

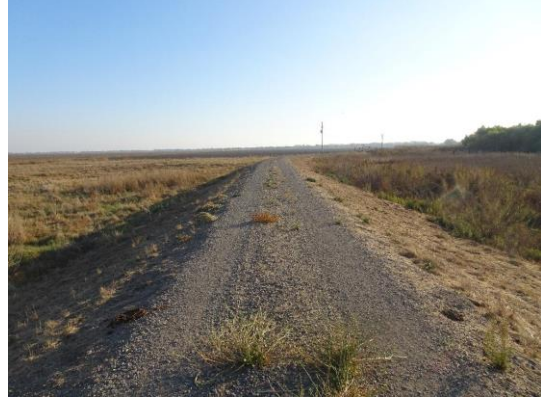
Photo 1 of 3 : UCIP_FA_2022_70718_90903.jpg

DS_ID:19598
FS_ID:70718
EP_NO: N/A
Repair Type: Non-Urgent
EVAL Issue:
Crossing Status: Found
UCIP Comments: 11/16/2020 Record remains Non-Urgent. Limited access due to steep slopes. No permit was found authorizing this encroachment. CVFPB will need to review crossing to determine owner. DWR DMP internal inspection is pending and scheduled for 2021. (B. Singh - GEI, O. Magana - DWR UCIP)04/25/2014 Recommend removing vegetation and sediment buildup from both waterward and landward concrete headwalls. (O. Magana - DWR UCIP)
FIELD_STRUCT_DESC: 24-inch corrugated metal (CM) gravity drainage pipe through the levee, 8.5 feet below the crown. Flap gate on the waterside (WS) end. Brass cap No. 40 bench mark (BM) on the headwall on the landside (LS). [Additional Reference(s): DWR Levee Log, 2002, (HLM 20.19). USACE San Joaquin O&M Manual, Unit No. 601, Part No. 1, (SJR601.1), 1967, Revised 25 May 2011, (HLM 20.18)].

Overview of levee crown looking upstream

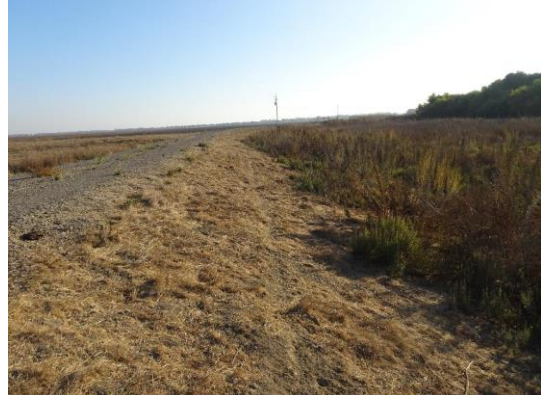
Photo 2 of 3 : UCIP_FA_2022_70718_90904.jpg

WS view: WS slope profile

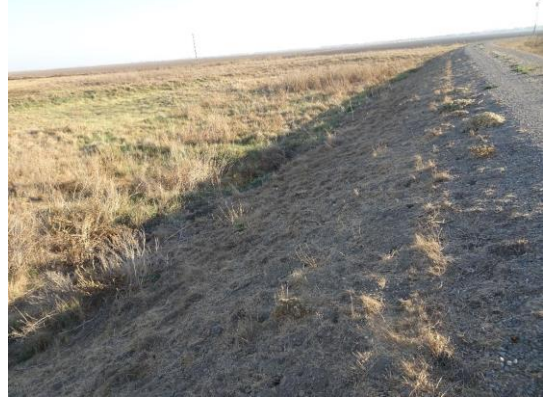
Photo 3 of 3 : UCIP_FA_2022_70718_90905.jpg

LS view: LS slope profile

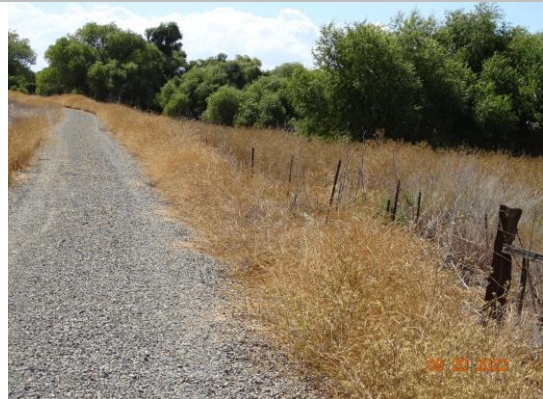
Photo 1 of 1 : FA_2022_NA0010_118_146_20221007_00301.jpg

View of vegetation on the waterside slope. (Fall 2022)

LM Start	20.25	Rating **	U	Issue No.	146
LM End	22.50	Issue Type +	Ma	Location *	WS
Category	Earthen Levee			GPS Latitude/Longitude	
				Start	End
Item	Vegetation			37.193687 °	37.167074 °
				-120.760120 °	-120.750233 °
DWR ID	DWR_NA0010_01_f _ 2022_146				
Comment Code					
V1 : Control annual grass and weeds on the levee slopes and easements.					
Inspector Comment

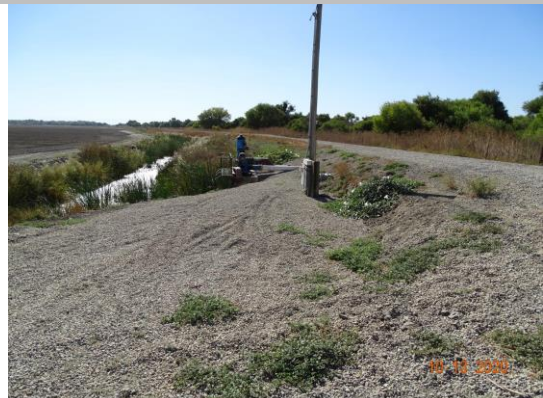
Photo 1 of 1 : FA_2022_NA0010_118_1184_20220822_00025.jpg

LM Start	20.25	Rating **	M	Issue No.	1184
LM End	20.25	Issue Type +	En	Location *	LS
Category	Earthen Levee			GPS Latitude/Longitude	
				Start	End
Item	Encroachments			37.193657 °	37.193657 °
				-120.760138 °	-120.760138 °
DWR ID	DWR_NA0010_01_s_2015_1184				
Comment Code					
RA : Ramp					
Inspector Comment					
Landowner installed unauthorized ramp on landside slope and toe.

Ramp cut into to the landside slope to access irrigation ditch at the landside toe. (Fall 2020)

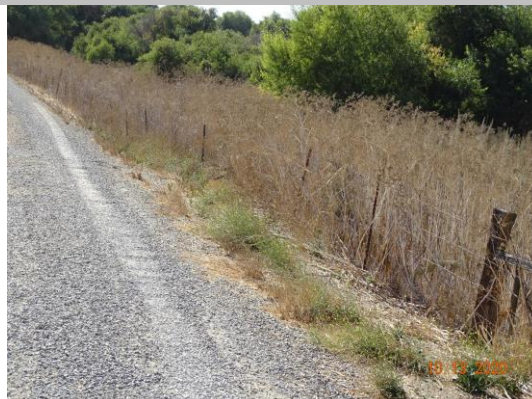
Photo 1 of 1 : FA_2022_NA0010_118_106_20220822_00009.jpg

LM Start	20.25	Rating **	M	Issue No.	106
LM End	22.51	Issue Type +	En	Location *	WS
Category	Earthen Levee			GPS Latitude/Longitude	
				Start	End
Item	Encroachments			37.193663 °	37.166957 °
				-120.760148 °	-120.750080 °
DWR ID	DWR_NA0010_01_f_2020_106				
Comment Code					
FE : Fence					
Inspector Comment

Barbed wire fence along the waterside slope. (Fall 2020)

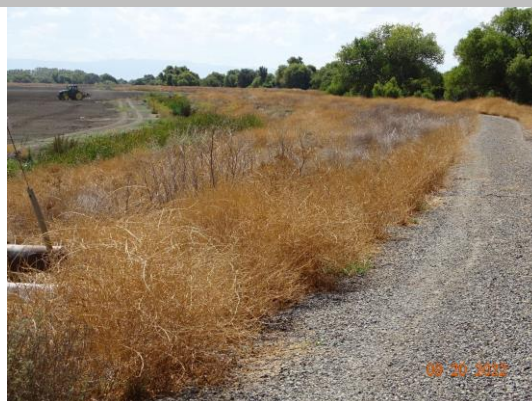
Photo 1 of 1 : FA_2022_NA0010_118_147_20221007_00302.jpg

Looking upstream along the landside slope. (Fall 2022)

LM Start	20.26	Rating **	U	Issue No.	147
LM End	22.50	Issue Type +	Ma	Location *	LS
Category	Earthen Levee			GPS Latitude/Longitude	
				Start	End
Item	Vegetation			37.193630 °	37.167067 °
				-120.760183 °	-120.750222 °
DWR ID	DWR_NA0010_01_f_2022_147				
Comment Code					
V1 : Control annual grass and weeds on the levee slopes and easements.					
Inspector Comment

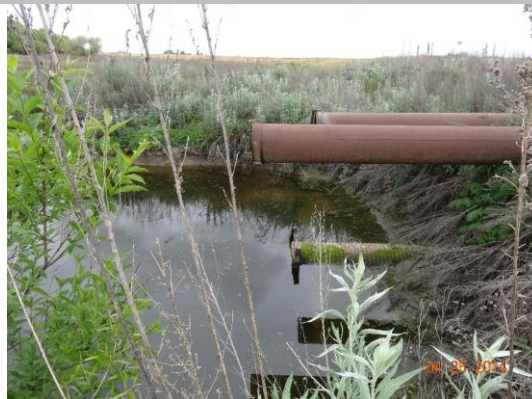
Photo 1 of 2 : UCIP_FA_2022_70721_66309.jpg

DS_ID:19600
FS_ID:70721
EP_NO: N/A
Repair Type: Non-Urgent
EVAL Issue:
Crossing Status: Found
UCIP Comments: 11/16/2020 Record remains Non-Urgent. Dense vegetation and fence on the WS prevented proper inspection of pipe. No permit has been found authorizing this pipe. CVFPB will need to review crossing to determine owner. (O. Magana - DWR UCIP)04/25/2014 Crossing partially submersed--no signs of failure of pipe present along pipe alignment. Recommend contacting owner to determine status of crossing and condition. (O. Magana - DWR UCIP) FIELD_STRUCT_DESC: 36-inch corrugated metal (CM) gravity drainage pipe through the levee, 10.5 feet below the crown. Flap gate on the waterside (WS) end. Brass cap No. 40 bench mark (BM) on the headwall on the landside (LS). [Additional Reference(s): DWR Levee Log, 2002, (HLM 20.28). USACE San Joaquin O&M Manual, Unit No. 601, Part No. 1, (SJR601.1), 1967, Revised 25 May 2011, (HLM 20.27)]. FS Date: 11/6/2020

Multiple crossings visible on waterward side--36 inch CMP is submersed in water.

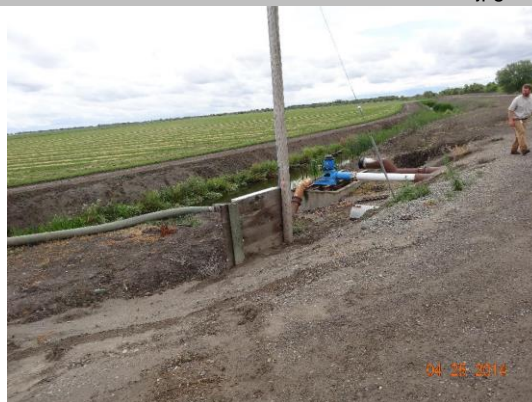
Photo 2 of 2 : UCIP_FA_2022_70721_66307.jpg

View of landward side.

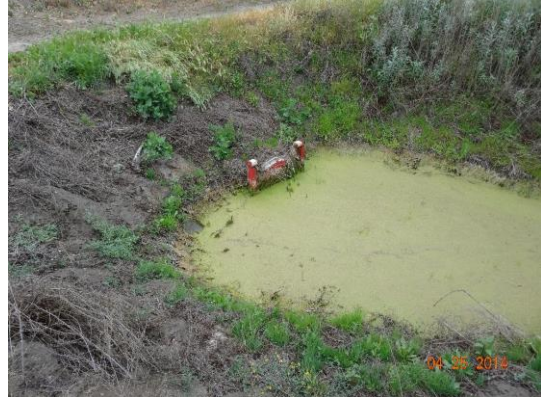
Photo 1 of 3 : UCIP_FA_2022_70727_66313.jpg

Comment Code					
Inspector Comment					
DS_ID:19603 FS_ID:70727 EP_NO: N/A Repair Type: Non-Urgent EVAL Issue: Crossing Status: Found UCIP Comments: 05/06/2021 Record remains Non-Urgent. This crossing appears to be non-functional based on the 2014 UCIP inspection. No field inspection has been completed by UCIP. DWR DMP internal inspection is pending and scheduled for 2021. Recommend having UCIP inspector or Levee inspector take current photos of the site. (O. Magana - DWR UCIP)04/25/2014 Crossing is non-functional--crossing buried on landward side. Need to contact owner to determine status of crossing. If crossing is no longer used need to coordinate with CVFPB for proper abandonment. (O. Magana - DWR UCIP) FIELD_STRUCT_DESC: 36-inch corrugated metal (CM) gravity drainage pipe through the levee, 11.5 feet below the crown. Flap gate on the waterside (WS) end. Brass cap No. 40 bench mark (BM) on the headwall on the landside (LS). [Additional Reference(s): DWR Levee Log, 2002, (HLM 21.41). USACE San Joaquin O&M Manual, Unit No. 601, Part No. 1, (SJR601.1), 1967, Revised 25 May 2011, (HLM 21.40)]. FS Date: 5/16/2021

Flap gate half way submersed located on waterward side.

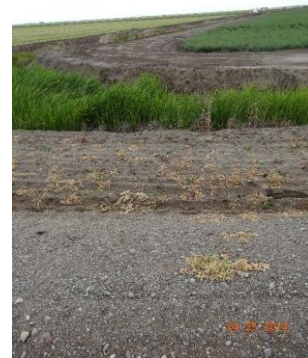
Photo 2 of 3 : UCIP_FA_2022_70727_66311.jpg

View of landward side.

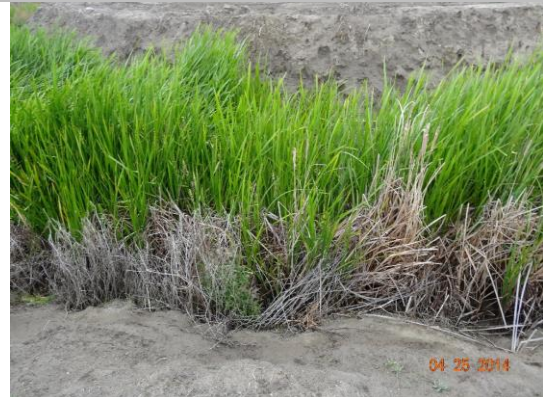
Photo 3 of 3 : UCIP_FA_2022_70727_66310.jpg

No signs of concrete headwall on landward toe.

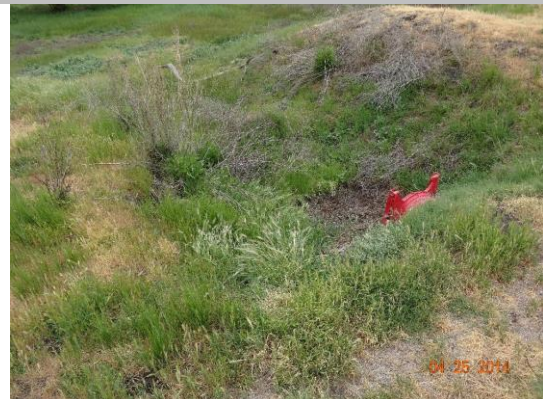
Photo 1 of 2 : UCIP_FA_2022_70728_65695.jpg

DS_ID:19604
 FS_ID:70728
 EP_NO: N/A
 Repair Type: Non-Urgent
 EVAL Issue:
 Crossing Status: Found
 UCIP Comments: 05/06/2021 Record remains Non-Urgent. This crossing appears to be non-functional based on the 2014 UCIP inspection. No field inspection has been completed by UCIP. DWR DMP internal inspection is pending and scheduled for 2021. Recommend having UCIP inspector or Levee inspector take current photos of the site. (O. Magana - DWR UCIP)04/25/2014 Non-functional crossing-landward side is buried. Need to contact owner to determine status of crossing. If crossing is no longer used need to coordinate with CVFPB for proper abandonment. (O. Magana - DWR UCIP)
 FIELD_STRUCT_DESC: 24-inch corrugated metal (CM) gravity drainage pipe through the levee, 9.0 feet below the crown. Flap gate on the waterside (WS) end. Brass cap No. 40 bench mark (BM) on the headwall on the landside (LS). [Additional Reference(s): DWR Levee Log, 2002, (HLM 21.78). USACE San Joaquin O&M Manual, Unit No. 601, Part No. 1, (SJR601.1), 1967, Revised 25 May 2011, (HLM 21.76)].

Flap gate visible on waterward side.

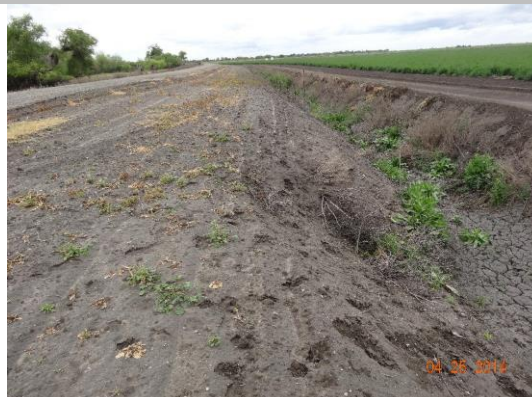
Photo 2 of 2 : UCIP_FA_2022_70728_65698.jpg

Crossing not found on landward side. No signs on canal located on landward side.

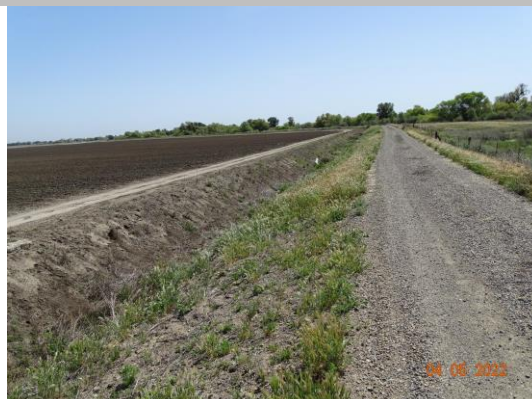
Photo 1 of 1 : FA_2022_NA0010_118_22_20220822_00004.jpg

LM Start	22.06	Rating **	A/W	Issue No.	22
LM End	22.52	Issue Type +	En	Location *	LS
Category	Earthen Levee			GPS Latitude/Longitude	
				Start	End
Item	Encroachments			37.172074 °	37.166906 °
				-120.754628 °	-120.749962 °
DWR ID	DWR_NA0010_01_s_2020_22				
Comment Code					
DT : Ditch					
Inspector Comment

Looking upstream at irrigation at landside toe. (Spring 2022)

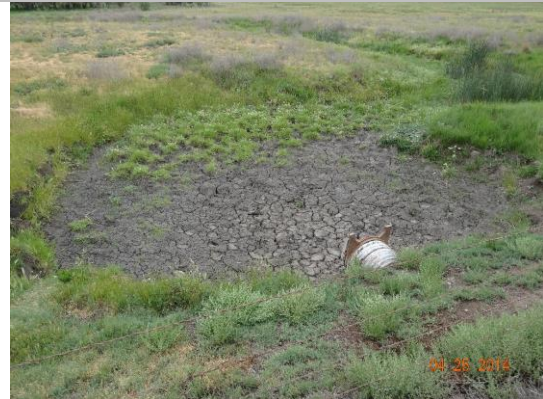
Photo 1 of 2 : UCIP_FA_2022_70729_65707.jpg

Comment Code					
Inspector Comment					
DS_ID:19605 FS_ID:70729 EP_NO: N/A Repair Type: Non-Urgent EVAL Issue: Crossing Status: Found UCIP Comments: 05/06/2021 Record remains Non-Urgent. This crossing appears to be non-functional based on the 2014 UCIP inspection. No field inspection has been completed by UCIP. DWR DMP internal inspection is pending and scheduled for 2021. Recommend having UCIP inspector or Levee inspector take current photos of the site. (O. Magana - DWR UCIP)04/25/2014 Non-functional crossing--landward side is buried. Need to contact owner to determine status. If crossing is no longer used need to coordinate with CVFPB for proper abandonment. (O. Magana - DWR UCIP) FIELD_STRUCT_DESC: 24-inch corrugated metal (CM) gravity drainage pipe through the levee, 9.0 feet below the crown. Flap gate on the waterside (WS) end. Wooden headboards on the landside (LS) end. Brass cap No. 31 bench mark (BM) on the headwall on the LS. [Additional Reference(s): DWR Levee Log, 2002, (HLM 22.13). USACE San Joaquin O&M Manual, Unit No. 601, Part No. 1, (SJR601.1), 1967, Revised 25 May 2011, (HLM 22.13)]. FS Date: 5/6/2021 9:50:00 AM

Flap gate visible on waterward side.

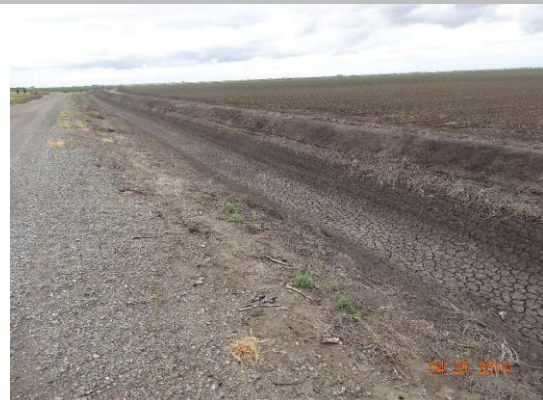
Photo 2 of 2 : UCIP_FA_2022_70729_65710.jpg

View of landward side.

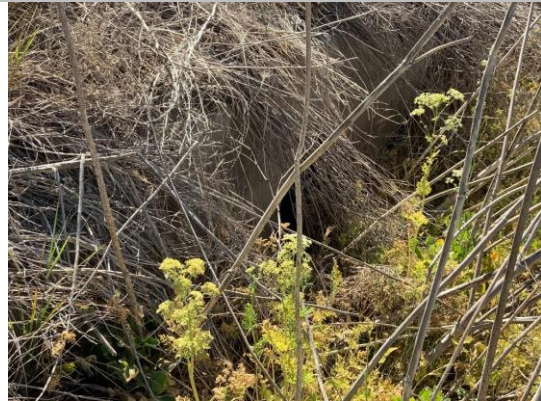
Photo 1 of 1 : UCIP_FA_2022_70933_100059.jpg

Comment Code						
Inspector Comment						
DS_ID:19652 FS_ID:70933 EP_NO: N/A Repair Type: Non-Urgent EVAL Issue: 11, Maintenance Compliance Issue Crossing Status: Found UCIP Comments: 06/8/2021 Record remains Non-Urgent. There is dense vegetation around the LS pipe inlet, recommend removing to better inspect pipe. No permit was found authorizing this encroachment. CVFPB will need to review crossing to determine owner. The UCIP inspection was completed with GEI staff, P. Espinoza. (H. Dunn – GEI) 05/01/2014 Dense vegetation limits the inspector's visibility to identify signs of pipe failure (leaks) along the slope. Recommend removing vegetation along pipe alignment to conduct proper inspection of structure. (O. Magana - DWR UCIP) FIELD_STRUCT_DESC: 24-inch corrugated metal gravity drainage pipe (CMP) through the levee, 11.0 feet below the crown. Flap gate on the waterside (WS) end. Brass cap No. 139 bench mark (BM) on the headwall on the landside (LS). [Additional Reference(s): DWR Levee Log, 2002, (HLM 0.24). USACE San Joaquin O&M Manual, Unit No. 601, Part No. 1, 1967, Amended in 1978, Revised 20 June 1985, (HLM 0.24)]. FS Date: 6/8/2021

LS view: Close up of pipe inlet at toe, vegetation covering opening.

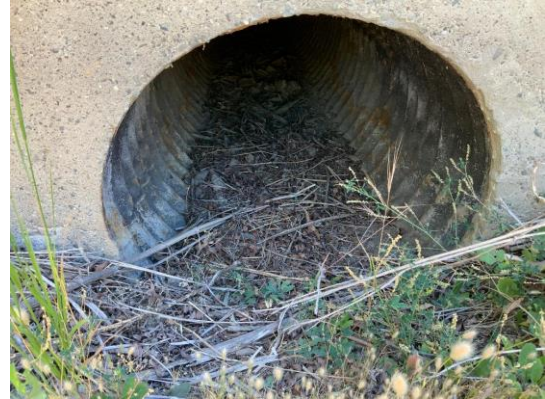
Photo 1 of 1 : UCIP_FA_2022_70934_100065.jpg

Comment Code						
Inspector Comment						
DS_ID:19653 FS_ID:70934 EP_NO: N/A Repair Type: Non-Urgent EVAL Issue: 11, Maintenance Compliance Issue Crossing Status: Found UCIP Comments: 06/8/2021 The record remains Non-Urgent. Some vegetation debris inside LS pipe inlet, recommend removal. No permit was found authorizing this encroachment. CVFPB will need to review crossing to determine owner. The UCIP inspection was completed with GEI staff, P. Espinoza. (H. Dunn – GEI) 05/01/2014 Dense vegetation limits the inspector's visibility to identify signs of pipe failure (leaks) along the slope. Recommend removing vegetation along pipe alignment to conduct proper inspection of structure. (O. Magana - DWR UCIP) FIELD_STRUCT_DESC: 24-inch corrugated metal gravity drainage pipe (CMP) through the levee, 14.8 feet below the crown. Flap gate on the waterside (WS) end. Brass cap No. 138 bench mark (BM) on the headwall on the landside (LS). [Additional Reference(s): DWR Levee Log, 2002, (HLM 0.69). USACE San Joaquin O&M Manual, Unit No. 601, Part No. 1, 1967, Amended in 1978, Revised 20 June 1985, (HLM 0.67)]. FS Date: 6/8/2021

LS view: Close up of pipe inlet at toe, some debris buildup.

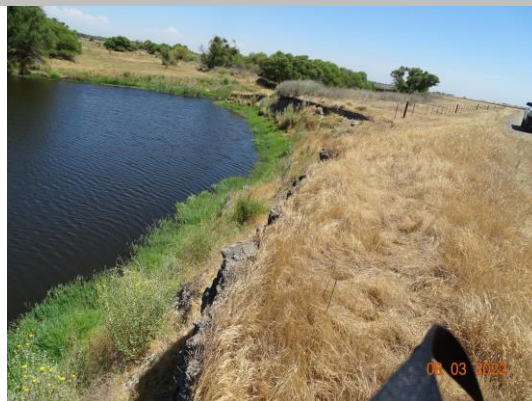
Photo 2 of 3 : SJR2022_NA0010U02RM129.22_6.JPG

LM Start	0.68	Rating **	U	Issue No.	1 (cont)
LM End	0.74	Issue Type +	Ma	Location *	
Category	Supplemental		GPS Latitude/Longitude		
			Start	End	
Item	DWR Erosion Survey		37.287517 °	37.287517 °	
			-120.874583 °	-120.874583 °	
DWR ID	NA0010U02ARM129.22

8/3/2022: View of the eroded levee looking upstream.

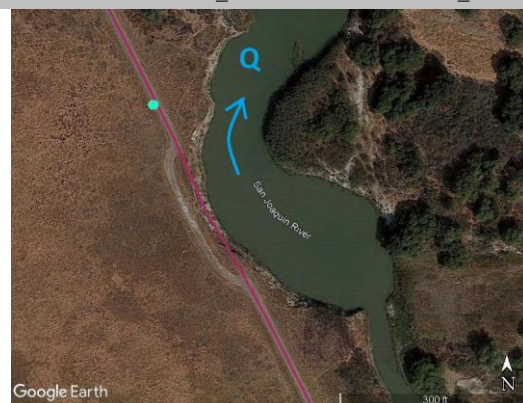
Photo 3 of 3 : SJR2022_NA0010U02ARM129.22_GE.JPG

8/31/2022: Aerial view of the erosion site (Google Earth Imagery from 8/27/2020).

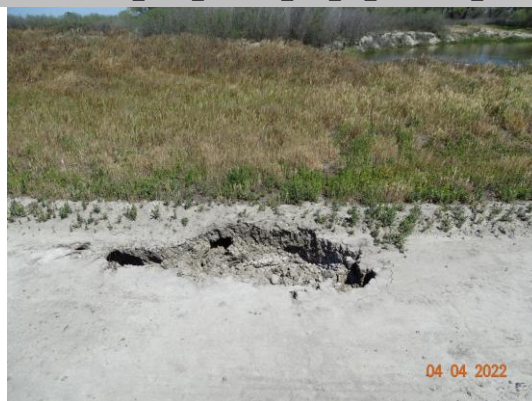
Photo 1 of 1 : FA_2022_NA0010_119_26_20220822_00006.jpg

LM Start	0.74	Rating **	M	Issue No.	26
LM End	0.74	Issue Type +	Ma	Location *	LS
Category	Earthen Levee			GPS Latitude/Longitude	
				Start	End
Item	Animal Control			37.287094 °	37.287094 °
				-120.874422 °	-120.874422 °
DWR ID	DWR_NA0010_02A_s_2022_26				
Comment Code					
A3 : No rodents visible, but rodent burrows visible; need to backfill and compact or grout burrows.					
Inspector Comment					
Rodent burrow caved in along the landside toe. The toe is used in this section to bypass the erosion through the levee crown.

Ground on the landside toe collapsed from rodent activity. (Spring 2022)

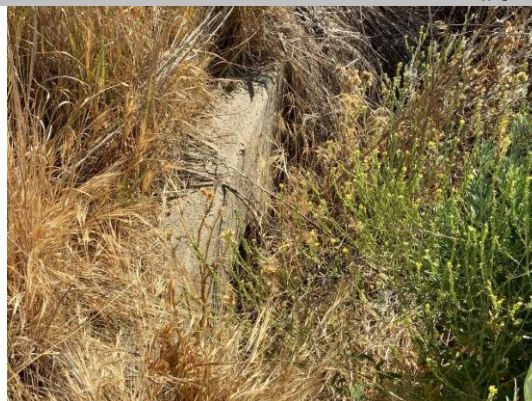
Photo 1 of 1 : UCIP_FA_2022_70935_100076.jpg

Comment Code						
Inspector Comment						
<p>DS_ID:19654 FS_ID:70935 EP_NO: N/A Repair Type: Non-Urgent EVAL Issue: 11, Maintenance Compliance Issue Crossing Status: Found UCIP Comments: 06/8/2021 The record remains Non-Urgent. Dense vegetation on LS slope, could not inspect pipe inlet, recommend clearing. No permit was found authorizing this encroachment. CVFPB will need to review crossing to determine owner. The UCIP inspection was completed with GEI staff, P. Espinoza. (H. Dunn – GEI)</p> <p>05/01/2014 Dense vegetation limits the inspector's visibility to identify signs of pipe failure (leaks) along the slope. Recommend removing vegetation along pipe alignment to conduct proper inspection of structure. Sediment buildup in pipe recommend clearing. (O. Magana - DWR UCIP)</p> <p>FIELD_STRUCT_DESC: 24-inch corrugated metal gravity drainage pipe (CMP) through the levee, 8.6 feet below the crown. Flap gate on the waterside (WS) end. Brass cap No. 137 bench mark (BM) on the headwall on the landside (LS). [Additional Reference(s): DWR Levee Log, 2002, (HLM 1.03). USACE San Joaquin O&M Manual, Unit No. 601, Part No. 1, 1967, Amended in 1978, Revised 20 June 1985, (HLM 1.02)].</p> <p>FS Date: 6/8/2021</p>

LS view: Close up of pipe inlet and headwall, covered by vegetation.

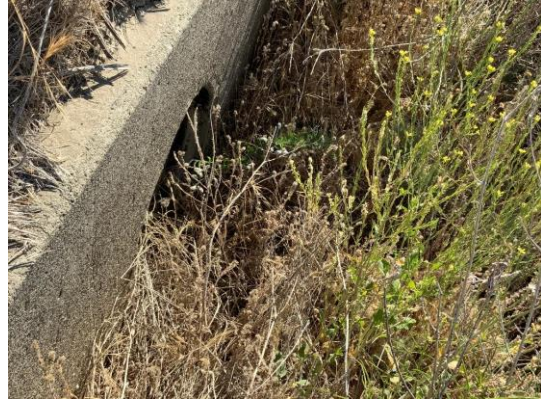
Photo 1 of 1 : UCIP_FA_2022_70936_100081.jpg

Comment Code						
Inspector Comment						
DS_ID:19655 FS_ID:70936 EP_NO: N/A Repair Type: Non-Urgent EVAL Issue: 11, Maintenance Compliance Issue Crossing Status: Found UCIP Comments: 06/8/2021 The record remains Non-Urgent. Dense vegetation over LS pipe inlet, recommend clearing out for easier pipe inspection. No permit was found authorizing this encroachment. CVFPB will need to review crossing to determine owner. The UCIP inspection was completed with GEI staff, P. Espinoza. (H. Dunn – GEI)						
05/01/2014 Dense vegetation limits the inspector's visibility to identify signs of pipe failure (leaks) along the slope. Recommend removing vegetation along pipe alignment to conduct proper inspection of structure. (O. Magana - DWR UCIP) FIELD_STRUCT_DESC: 24-inch corrugated metal gravity drainage pipe (CMP) through the levee, 8.6 feet below the crown. Flap gate on the waterside (WS) end. Brass cap No. 136 bench mark (BM) on the headwall on the landside (LS). [Additional Reference(s): DWR Levee Log, 2002, (HLM 1.23). USACE San Joaquin O&M Manual, Unit No. 601, Part No. 1, 1967, Amended in 1978, Revised 20 June 1985, (HLM 1.22)]. FS Date: 6/8/2021

LS view: Headwall and inlet barely visible at toe due to vegetation.

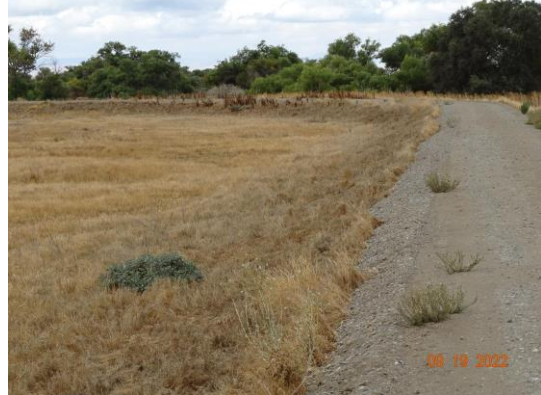
Photo 1 of 1 : FA_2022_NA0010_119_24_20221010_00068.jpg

LM Start	1.28	Rating **	M	Issue No.	24
LM End	3.39	Issue Type +	Ma	Location *	LS
Category	Earthen Levee			GPS Latitude/Longitude	
				Start	End
Item	Vegetation			37.286331 °	37.278410 °
				-120.866843 °	-120.843876 °
DWR ID	DWR_NA0010_02A_f_2022_24				
Comment Code					
V1 : Control annual grass and weeds on the levee slopes and easements.					
Inspector Comment

View of the landside slope looking downstream. (Fall 2022)

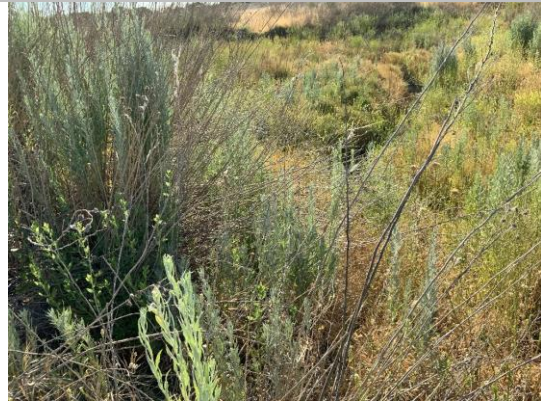
Photo 1 of 2 : UCIP_FA_2022_70937_100089.jpg

Comment Code						
Inspector Comment						
DS_ID:19656 FS_ID:70937 EP_NO: N/A Repair Type: Non-Urgent EVAL Issue: 11, Maintenance Compliance Issue Crossing Status: Found UCIP Comments: 06/8/2021 The record remains Non-Urgent. Dense LS vegetation limits inspection of pipe inlet, headwall and inlet not visible at all, recommend clearing. WS flapgate seen with vegetation sticking out of it, recommend removal. No permit was found authorizing this encroachment. CVFPB will need to review crossing to determine owner. The UCIP inspection was completed with GEI staff, P. Espinoza. (H. Dunn – GEI) 05/01/2014 Dense vegetation limits the inspector's visibility to identify signs of pipe failure (leaks) along the slope. Recommend removing vegetation along pipe alignment to conduct proper inspection of structure. (O. Magana - DWR UCIP) FIELD_STRUCT_DESC: 36-inch corrugated metal gravity drainage pipe (CMP) through the levee, 14.6 feet below the crown. Flap gate on the waterside (WS) end. Brass cap No. 135 bench mark (BM) on the headwall on the landside (LS). [Additional Reference(s): DWR Levee Log, 2002, (HLM 1.36). USACE San Joaquin O&M Manual, Unit No. 601, Part No. 1, 1967, Amended in 1978, Revised 20 June 1985, (HLM 1.34)]. FS Date: 6/8/2021

LS view: Dense vegetation, headwall and pipe inlet not visible.

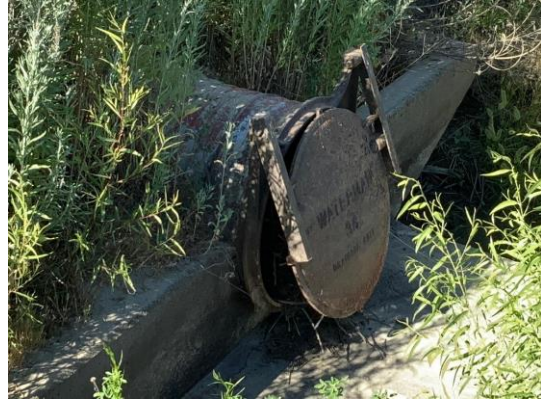
Photo 2 of 2 : UCIP_FA_2022_70937_100085.jpg

WS view: Close up of flapgate, vegetation within pipe.

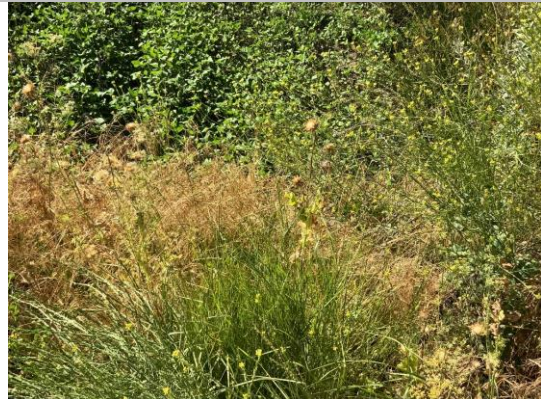
Photo 1 of 2 : UCIP_FA_2022_70938_100096.jpg

DS_ID:19657
 FS_ID:70938
 EP_NO: N/A
 Repair Type: Non-Urgent
 EVAL Issue: 11, Maintenance Compliance Issue
 Crossing Status: Found
 UCIP Comments: 06/8/2021 The record remains Non-Urgent. Both WS and LS pipe ends are heavily vegetated. Headwalls and flapgate were just barely visible, recommend removal of vegetation on both sides. No permit was found authorizing this encroachment. CVFPB will need to review crossing to determine owner. The UCIP inspection was completed with GEI staff, P. Espinoza. (H. Dunn – GEI) 05/01/2014
 Dense vegetation limits the inspector's visibility to identify signs of pipe failure (leaks) along the slope. Recommend removing vegetation along pipe alignment to conduct proper inspection of structure. (O. Magana - DWR UCIP)
 FIELD_STRUCT_DESC: 24-inch corrugated metal gravity drainage pipe (CMP) through the levee, 10.2 feet below the crown. Flap gate on the waterside (WS) end. Brass cap No. 135 bench mark (BM) on the headwall on the landside (LS). [Additional Reference(s): DWR Levee Log, 2002 (HLM 1.63). USACE San Joaquin O&M Manual, Unit No. 601, Part No. 1, 1967, Amended in 1978, Revised 20 June 1985, (HLM 1.62)].

LS view: Headwall and inlet covered in vegetation at toe.

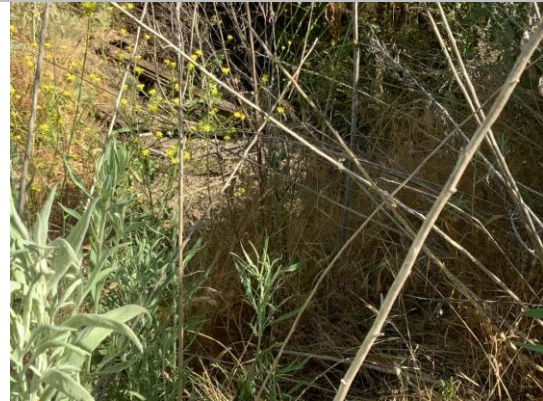
Photo 2 of 2 : UCIP_FA_2022_70938_100092.jpg

WS view: Flapgate covered by vegetation at toe.

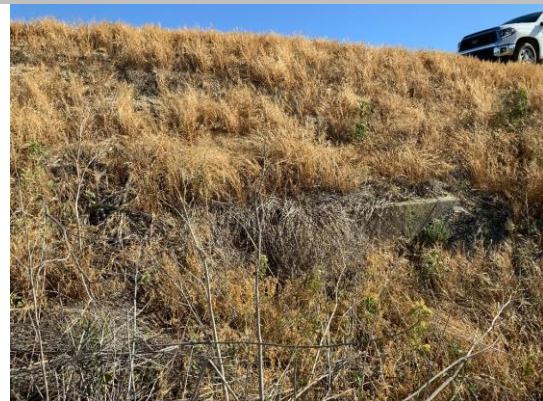
Photo 1 of 1 : UCIP_FA_2022_70939_100102.jpg

DS_ID:19658
 FS_ID:70939
 EP_NO: N/A
 Repair Type: Non-Urgent
 EVAL Issue: 11, Maintenance Compliance Issue
 Crossing Status: Found
 UCIP Comments: 06/8/2021 The record remains Non-Urgent. Dense vegetation covering LS pipe inlet, recommend removal. No permit was found authorizing this encroachment. CVFPB will need to review crossing to determine owner. The UCIP inspection was completed with GEI staff, P. Espinoza. (H. Dunn – GEI) 05/01/2014 Dense vegetation limits the inspector's visibility to identify signs of pipe failure (leaks) along the slope. Recommend removing vegetation along pipe alignment to conduct proper inspection of structure. (O. Magana - DWR UCIP)
 FIELD_STRUCT_DESC: 24-inch corrugated metal gravity drainage pipe (CMP) through the levee, 10.7 feet below the crown. Flap gate on the waterside (WS) end. Brass cap No. 135 bench mark (BM) on the headwall on the landside (LS). [Additional Reference(s): DWR Levee Log, 2002, (HLM 1.88). USACE San Joaquin O&M Manual, Unit No. 601, Part No. 1, 1967, Amended in 1978, Revised 20 June 1985, (HLM 1.86)].

LS view: Slope and headwall from toe.

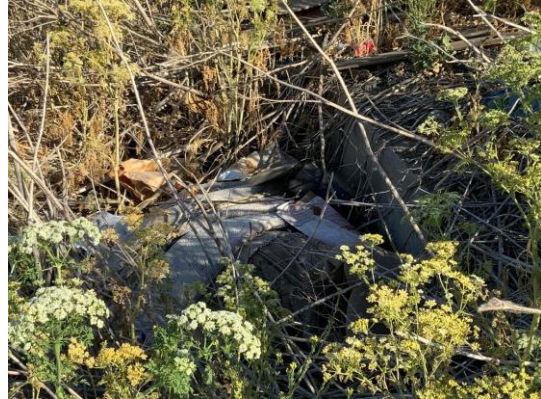
Photo 1 of 1 : UCIP_FA_2022_70940_100108.jpg

Comment Code					
Inspector Comment					
DS_ID:19659 FS_ID:70940 EP_NO: N/A Repair Type: Non-Urgent EVAL Issue: 11, Maintenance Compliance Issue Crossing Status: Found UCIP Comments: 06/8/2021 The record remains Non-Urgent. LS pipe inlet covered by trash and debris, recommend clearing out. No permit was found authorizing this encroachment. CVFPB will need to review crossing to determine owner. The UCIP inspection was completed with GEI staff, P. Espinoza. (H. Dunn – GEI) 05/01/2014 Dense vegetation limits the inspector's visibility to identify signs of pipe failure (leaks) along the slope. Recommend removing vegetation along pipe alignment to conduct proper inspection of structure. (O. Magana - DWR UCIP) FIELD_STRUCT_DESC: 24-inch corrugated metal gravity drainage pipe (CMP) through the levee, 7.0 feet below the crown. Flap gate on the waterside (WS) end. Brass cap No. 135 bench mark (BM) on the headwall on the landside (LS). [Additional Reference(s): DWR Levee Log, 2002, (HLM 2.32). USACE San Joaquin O&M Manual, Unit No. 601, Part No. 1, 1967, Amended in 1978, Revised 20 June 1985, (HLM 2.30)]. FS Date: 6/8/2021

LS view: Close up of pipe inlet covered with trash and debris.

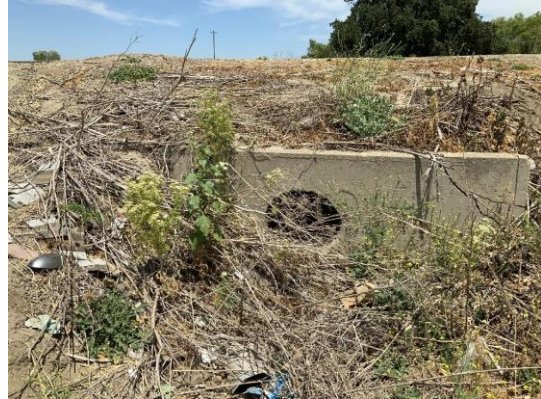
Photo 1 of 1 : UCIP_FA_2022_70941_100118.jpg

Comment Code					
Inspector Comment					
DS_ID:19660 FS_ID:70941 EP_NO: N/A Repair Type: Non-Urgent EVAL Issue: 11, Maintenance Compliance Issue Crossing Status: Found UCIP Comments: 06/8/2021 The record remains Non-Urgent. Vegetation present at pipe inlet on LS, recommend removal. No permit was found authorizing this encroachment. CVFPB will need to review crossing to determine owner. The UCIP inspection was completed with GEI staff, P. Espinoza. (H. Dunn ? GEI) 05/01/2014 Dense vegetation limits the inspector's visibility to identify signs of pipe failure (leaks) along the slope. Recommend removing vegetation along pipe alignment to conduct proper inspection of structure. (O. Magana - DWR UCIP) FIELD_STRUCT_DESC: 24-inch corrugated metal gravity drainage pipe (CMP) through the levee, 7.0 feet below the crown. Flap gate on the waterside (WS) end. Brass cap No. 135 bench mark (BM) on the headwall on the landside (LS). [Additional Reference(s): DWR Levee Log, 2002, (HLM 2.34). USACE San Joaquin O&M Manual, Unit No. 601, Part No. 1, 1967, Amended in 1978, Revised 20 June 1985, (HLM 2.32)]. FS Date: 6/8/2021

LS view: Slope and headwall at toe.

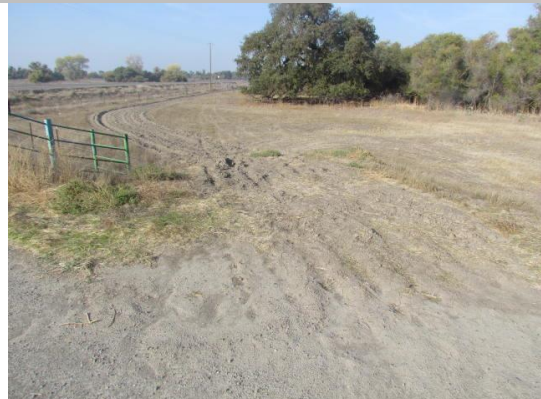
Photo 1 of 1 : FA_2022_NA0010_119_2_20220822_00004.jpg

LM Start	2.32	Rating **	M	Issue No.	2
LM End	2.32	Issue Type +	En	Location *	LS
Category	Earthen Levee			GPS Latitude/Longitude	
				Start	End
Item	Encroachments			37.291433 °	37.291433 °
				-120.850917 °	-120.850917 °
DWR ID	DWR_NA0010_02A_s_2012_2				
Comment Code					
RA : Ramp					
Inspector Comment					
Unauthorized ramps are located on the landside and waterside slopes.

Looking northeast at unauthorized ramp on landward slope.

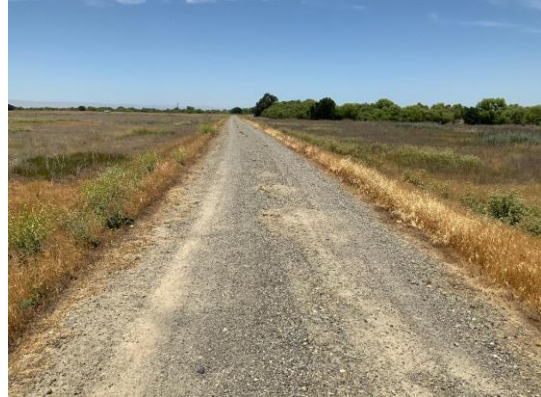
Photo 1 of 3 : UCIP_FA_2022_70942_100127.jpg

Comment Code						
Inspector Comment						
DS_ID:19661 FS_ID:70942 EP_NO: N/A Repair Type: Non-Urgent EVAL Issue: Crossing Status: Found UCIP Comments: 06/8/2021 The record remains Non-Urgent. Vegetation on LS and WS limited close up inspection of flapgate and pipe inlet. No permit was found authorizing this encroachment. CVFPB will need to review crossing to determine owner. The UCIP inspection was completed with GEI staff, P. Espinoza. (H. Dunn – GEI) 05/01/2014 Dense vegetation limits the inspector's visibility to identify signs of pipe failure (leaks) along the slope. Recommend removing vegetation along pipe alignment to conduct proper inspection of structure. (O. Magana - DWR UCIP) FIELD_STRUCT_DESC: 24-inch corrugated metal gravity drainage pipe (CMP) through the levee, 10.0 feet below the crown. Flap gate on the waterside (WS) end. Brass cap No. 130 bench mark (BM) on the headwall on the landside (LS). [Additional Reference(s): DWR Levee Log, 2002, (HLM 2.60). USACE San Joaquin O&M Manual, Unit No. 601, Part No. 1, 1967, Amended in 1978, Revised 20 June 1985, (HLM 2.59)]. FS Date: 6/8/2021

Levee crown looking downstream.

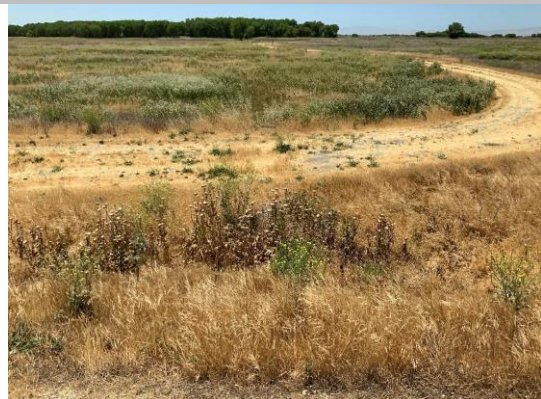
Photo 2 of 3 : UCIP_FA_2022_70942_100126.jpg

LS view: Toe from crown.

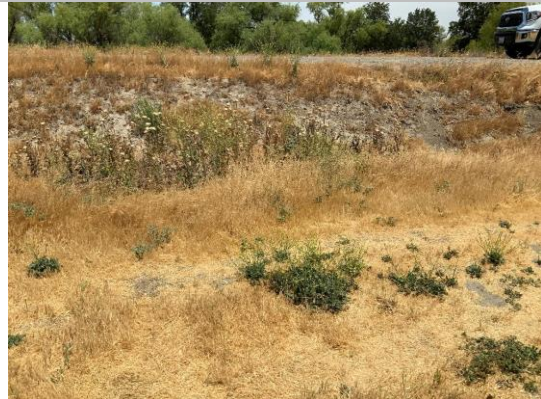
Photo 3 of 3 : UCIP_FA_2022_70942_100121.jpg

LS view: Slope from toe.

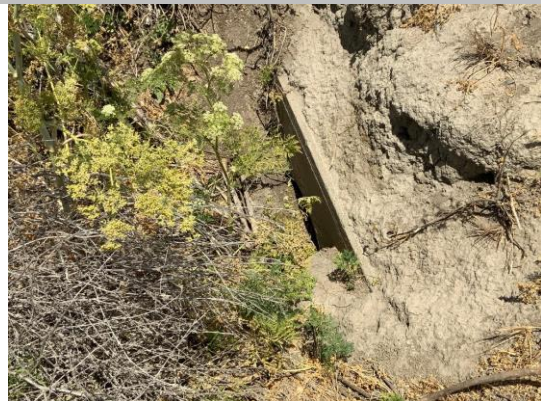
Photo 1 of 1 : UCIP_FA_2022_70943_100135.jpg

DS_ID:19662
 FS_ID:70943
 EP_NO: N/A
 Repair Type: Non-Urgent
 EVAL Issue: 11, Maintenance Compliance Issue
 Crossing Status: Found
 UCIP Comments: 06/7/2021 The record remains Non-Urgent. LS pipe inlet completely buried in sediment, recommend clearing out. No permit was found authorizing this encroachment. CVFPB will need to review crossing to determine owner. The UCIP inspection was completed with GEI staff, P. Espinoza. (H. Dunn – GEI) 05/01/2014 Dense vegetation limits the inspector's visibility to identify signs of pipe failure (leaks) along the slope. Recommend removing vegetation along pipe alignment to conduct proper inspection of structure. (O. Magana - DWR UCIP)
 FIELD_STRUCT_DESC: 24-inch corrugated metal gravity drainage pipe (CMP) through the levee, 10.0 feet below the crown. Flap gate on the waterside (WS) end. Brass cap No. 130 bench mark (BM) on the headwall on the landside (LS). [Additional Reference(s): DWR Levee Log, 2002, (HLM 2.97). USACE San Joaquin O&M Manual, Unit No. 601, Part No. 1, 1967, Amended in 1978, Revised 20 June 1985, (HLM 2.96)].

LS view: Headwall barely visible at toe, covered in sediment.

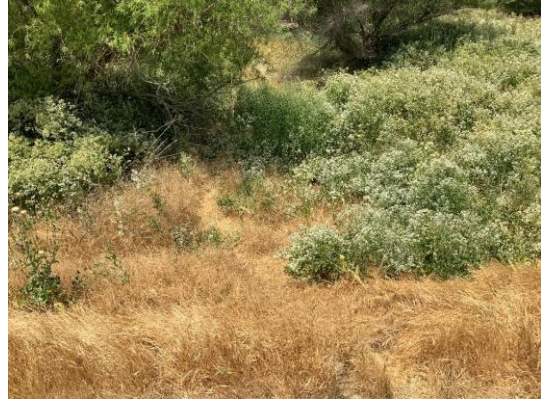
Photo 1 of 1 : UCIP_FA_2022_70944_100142.jpg

Comment Code						
Inspector Comment						
DS_ID:19665 FS_ID:70944 EP_NO: N/A Repair Type: Non-Urgent EVAL Issue: 11, Maintenance Compliance Issue Crossing Status: Found UCIP Comments: 06/7/2021 The record remains Non-Urgent. Dense vegetation limited view and inspection of LS pipe inlet. Recommend removal of LS vegetation. No permit was found authorizing this encroachment. CVFPB will need to review crossing to determine owner. The UCIP inspection was completed with GEI staff, P. Espinoza. (H. Dunn – GEI) 05/01/2014 Dense vegetation limits the inspector's visibility to identify signs of pipe failure (leaks) along the slope. Recommend removing vegetation along pipe alignment to conduct proper inspection of structure. (O. Magana - DWR UCIP) FIELD_STRUCT_DESC: 24-inch corrugated metal gravity drainage pipe (CMP) through the levee, 12.4 feet below the crown. Flap gate on the waterside (WS) end. Brass cap No. 130 bench mark (BM) on the headwall on the landside (LS). [Additional Reference(s): DWR Levee Log, 2002, (HLM 3.31). USACE San Joaquin O&M Manual, Unit No. 601, Part No. 1, 1967, Amended in 1978, Revised 20 June 1985, (HLM 3.29)]. FS Date: 6/7/2021

LS view: Toe from crown, pipe end not visible.

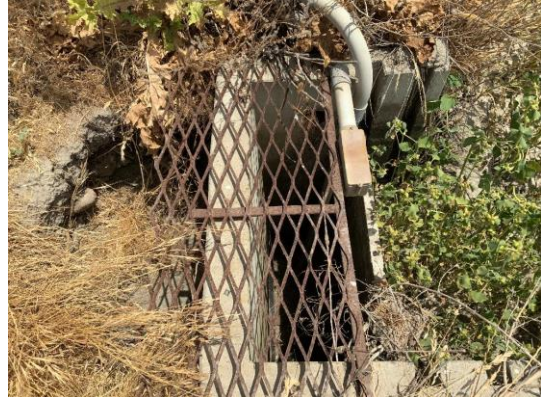
Photo 1 of 1 : UCIP_FA_2022_70945_100143.jpg

Comment Code						
Inspector Comment						
DS_ID:19666 FS_ID:70945 EP_NO: N/A Repair Type: Non-Urgent EVAL Issue: 11, Maintenance Compliance Issue Crossing Status: Found UCIP Comments: 06/7/2021 The record remains Non-Urgent. LS has boards blocking the open pipe inlet but there is significant sediment and vegetation on the other side of the boards, recommend cleaning around. No permit was found authorizing this encroachment. CVFPB will need to review crossing to determine owner. The UCIP inspection was completed with GEI staff, P. Espinoza. (H. Dunn – GEI) 05/01/2014 Dense vegetation limits the inspector's visibility to identify signs of pipe failure (leaks) along the slope. Recommend removing vegetation along pipe alignment to conduct proper inspection of structure. (O. Magana - DWR UCIP) FIELD_STRUCT_DESC: 24-inch corrugated metal gravity drainage pipe (CMP) through the levee, 10.0 feet below the crown. Flap gate on the waterside (WS) end. Brass cap No. 130 bench mark (BM) on the headwall on the landside (LS). [Additional Reference(s): DWR Levee Log, 2002, (HLM 3.63). USACE San Joaquin O&M Manual, Unit No. 601, Part No. 1, 1967, Amended in 1978, Revised 20 June 1985, (HLM 3.62)]. FS Date: 6/7/2021

LS view: Close up of pipe inlet and headwall. Sediment behind boards blocking pipe inlet.

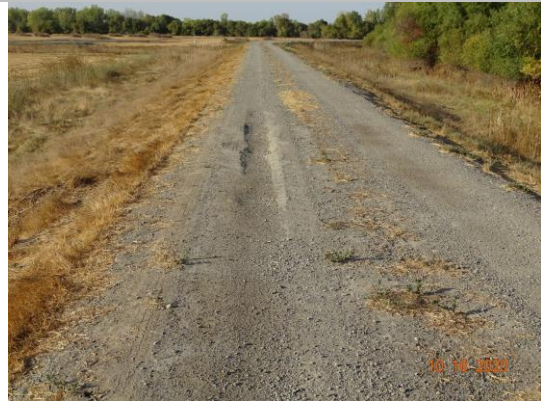
Photo 1 of 1 : FA_2022_NA0010_119_23_20220822_00005.jpg

LM Start	3.69	Rating **	A/W	Issue No.	23
LM End	3.69	Issue Type +	Ma	Location *	CR
Category	Earthen Levee			GPS Latitude/Longitude	
				Start	End
Item	Crown Surface / Depressions / Rutting			37.278949 °	37.278949 °
				-120.838776 °	-120.838776 °
DWR ID	DWR_NA0010_02A_f_2020_23				
Comment Code					
C2 : Repair depressions or ruts in the crown or slope.					
Inspector Comment

Rutting along the levee crown. (Fall 2020)

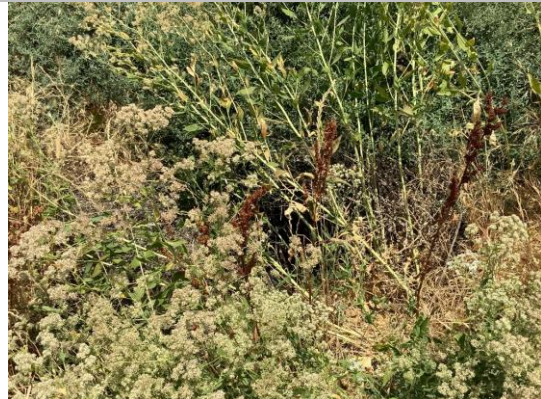
Photo 1 of 1 : UCIP_FA_2022_70946_100157.jpg

Comment Code						
Inspector Comment						
DS_ID:19667 FS_ID:70946 EP_NO: N/A Repair Type: Non-Urgent EVAL Issue: 11, Maintenance Compliance Issue Crossing Status: Found UCIP Comments: 06/7/2021 The record remains Non-Urgent. Dense vegetation around LS pipe inlet, recommend removal. No permit was found authorizing this encroachment. CVFPB will need to review crossing to determine owner. The UCIP inspection was completed with GEI staff, P. Espinoza. (H. Dunn – GEI) 05/01/2014 Signs of erosion or sink hole present on landward toe--Need to contact owner. Dense vegetation limits the inspector's visibility to identify signs of pipe failure (leaks) along the slope. Recommend removing vegetation along pipe alignment to conduct proper inspection of structure. (O. Magana - DWR UCIP) FIELD_STRUCT_DESC: 24-inch corrugated metal gravity drainage pipe (CMP) through the levee, 8.6 feet below the crown. Flap gate on the waterside (WS) end. Brass cap No. 130 bench mark (BM) on the headwall on the landside (LS). [Additional Reference(s): DWR Levee Log, 2002, (HLM 3.96). USACE San Joaquin O&M Manual, Unit No. 601, Part No. 1, 1967, Amended in 1978, Revised 20 June 1985, (HLM 3.95)]. FS Date: 6/7/2021

LS view: Close up of pipe inlet at toe covered in vegetation.
