Flood Control Project Maintenance Levee Inspections

Fall 2022 Levee Maintenance Deficiency Summary Report

San Joaquin River Basin

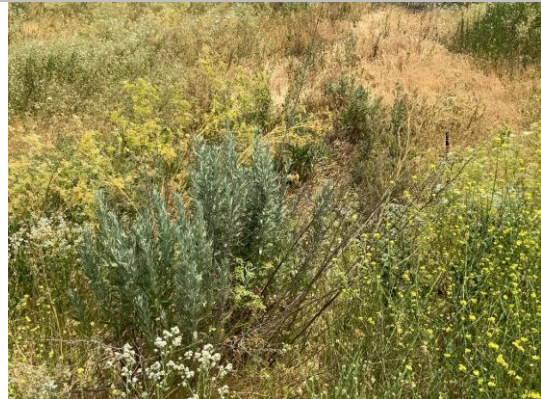
Photo 1 of 1 : UCIP_FA_2022_70947_100161.jpg

Comment Code						
Inspector Comment						
DS_ID:19668 FS_ID:70947 EP_NO: N/A Repair Type: Non-Urgent EVAL Issue: 11, Maintenance Compliance Issue Crossing Status: Found UCIP Comments: 06/7/2021 The record remains Non-Urgent. Limited inspection on WS due to dense vegetation, flapgate not visible, recommend clearing away. Limited insepction on LS due to canal limiting access to inlet. No permit was found authorizing this encroachment. CVFPB will need to review crossing to determine owner. The UCIP inspection was completed with GEI staff, P. Espinoza. (H. Dunn – GEI) 05/01/2014 Dense vegetation limits the inspector's visibility to identify signs of pipe failure (leaks) along the slope. Recommend removing vegetation along pipe alignment to conduct proper inspection of structure. (O. Magana - DWR UCIP) FIELD_STRUCT_DESC: 24-inch corrugated metal gravity drainage pipe (CMP) through the levee, 8.0 feet below the crown. Flap gate on the waterside (WS) end. Brass cap No. 125 bench mark (BM) on the headwall on the landside (LS). [Additional Reference(s): DWR Levee Log, 2002, (HLM 5.45). USACE San Joaquin O&M Manual, Unit No. 601, Part No. 1, 1967, Amended in 1978, Revised 20 June 1985, (HLM 5.43)]. FS Date: 6/7/2021

WS view: Flapgate completely covered by vegetation at toe.

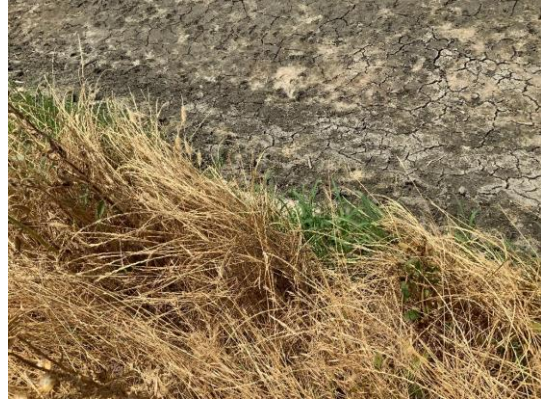
Photo 1 of 1 : UCIP_FA_2022_70948_100170.jpg

Comment Code					
Inspector Comment					
DS_ID:19669 FS_ID:70948 EP_NO: N/A Repair Type: Non-Urgent EVAL Issue: 11, Maintenance Compliance Issue Crossing Status: Found UCIP Comments: 06/7/2021 The record remains Non-Urgent. LS pipe inlet completely buried under sediment, recommend clearing out. No permit was found authorizing this encroachment. CVFPB will need to review crossing to determine owner. The UCIP inspection was completed with GEI staff, P. Espinoza. (H. Dunn – GEI) 05/01/2014 Dense vegetation limits the inspector's visibility to identify signs of pipe failure (leaks) along the slope. Recommend removing vegetation along pipe alignment to conduct proper inspection of structure. (O. Magana - DWR UCIP) FIELD_STRUCT_DESC: 24-inch corrugated metal gravity drainage pipe (CMP) through the levee, 7.7 feet below the crown. Flap gate on the waterside (WS) end. Brass cap No. 125 bench mark (BM) on the headwall on the landside (LS). [Additional Reference(s): DWR Levee Log, 2002, (HLM 6.06). USACE San Joaquin O&M Manual, Unit No. 601, Part No. 1, 1967, Amended in 1978, Revised 20 June 1985, (HLM 6.06)]. FS Date: 6/7/2021

LS view: Headwall barely visible at toe, buried under sediment.

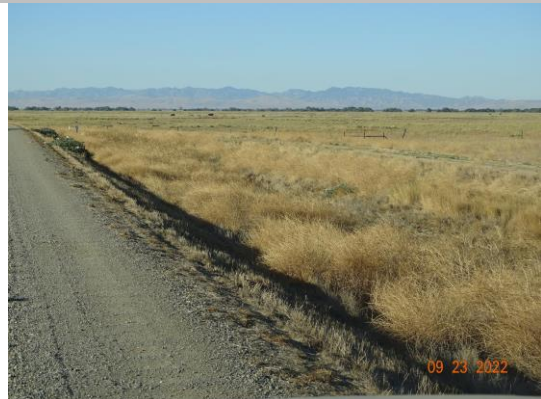
Photo 1 of 1 : FA_2022_NA0010_119_29_20221010_00069.jpg

LM Start	6.31	Rating **	M	Issue No.	29
LM End	6.73	Issue Type +	Ma	Location *	LS
Category	Earthen Levee			GPS Latitude/Longitude	
				Start	End
Item	Vegetation			37.250348 °	37.244500 °
				-120.822476 °	-120.822700 °
DWR ID	DWR_NA0010_02A_f _ 2022_29				
Comment Code					
V1 : Control annual grass and weeds on the levee slopes and easements.					
Inspector Comment

Looking upstream along the landside slope. (Fall 2022)

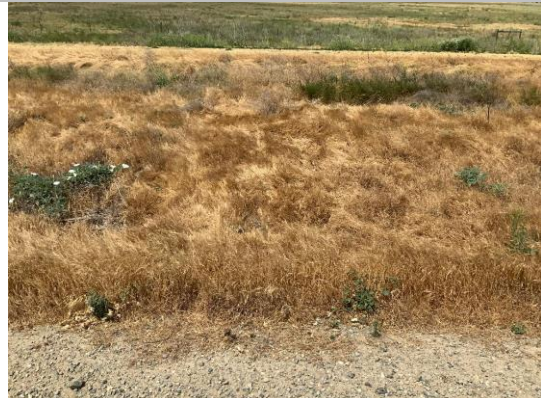
Photo 2 of 3 : UCIP_FA_2022_70949_100177.jpg

LS view: Toe from crown.

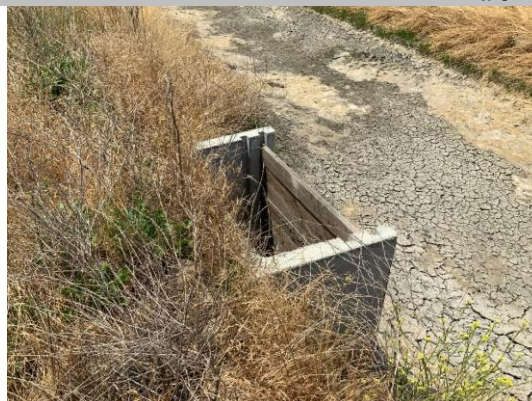
Photo 3 of 3 : UCIP_FA_2022_70949_100171.jpg

LS view: Close up of concrete box and pipe inlet.

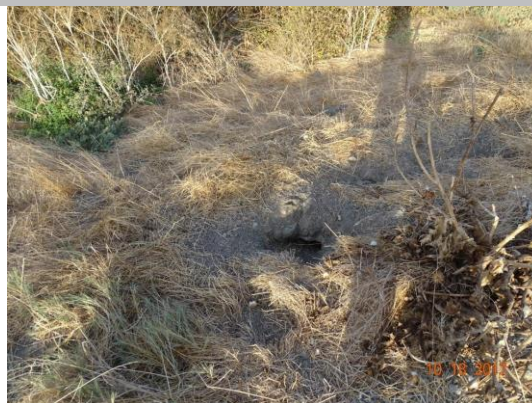
Photo 1 of 1 : FA_2022_NA0010_119_28_20220822_00007.jpg

LM Start	6.97	Rating **	A/W	Issue No.	28
LM End	6.97	Issue Type +	Ma	Location *	LS
Category	Earthen Levee			GPS Latitude/Longitude	
				Start	End
Item	Animal Control			37.241125 °	37.241125 °
				-120.821747 °	-120.821747 °
DWR ID	DWR_NA0010_02A_f_2017_28				
Comment Code					
A3 : No rodents visible, but rodent burrows visible; need to backfill and compact or grout burrows.					
Inspector Comment

Looking northwest at landside slope.

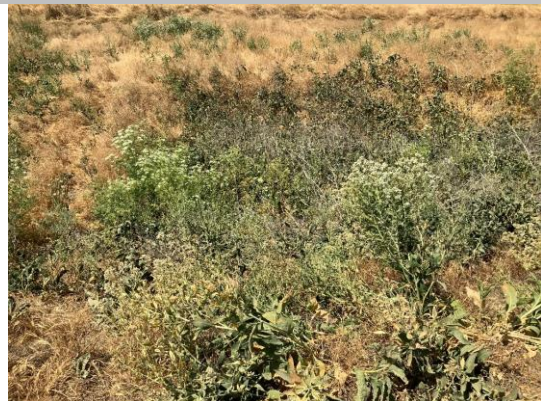
Photo 1 of 2 : UCIP_FA_2022_70952_100190.jpg

Comment Code						
Inspector Comment						
DS_ID:19673 FS_ID:70952 EP_NO: N/A Repair Type: Non-Urgent EVAL Issue: 11, Maintenance Compliance Issue Crossing Status: Found UCIP Comments: 06/7/2021 The record remains Non-Urgent. LS pipe end not visible, dense vegetation on both WS and LS ends, recommend removal. No permit was found authorizing this encroachment. CVFPB will need to review crossing to determine owner. The UCIP inspection was completed with GEI staff, P. Espinoza. (H. Dunn – GEI)05/01/2014 Dense vegetation limits the inspector's visibility to identify signs of pipe failure (leaks) along the slope. Recommend removing vegetation along pipe alignment to conduct proper inspection of structure. (O. Magana - DWR UCIP) FIELD_STRUCT_DESC: 24-inch corrugated metal gravity drainage pipe (CMP) through the levee, 8.0 feet below the crown. Flap gate on the waterside (WS) end. Brass cap No. 125 bench mark (BM) on the headwall on the landside (LS). [Additional Reference(s): DWR Levee Log, 2002, (HLM 7.78). USACE San Joaquin O&M Manual, Unit No. 601, Part No. 1, 1967, Amended in 1978, Revised 20 June 1985, (HLM 7.77)]. FS Date: 6/7/2021

LS view: Headwall and inlet not visible under vegetation.

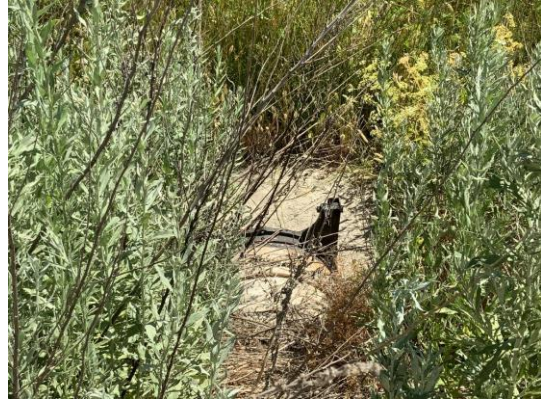
Photo 2 of 2 : UCIP_FA_2022_70953_100046.jpg

WS view: Flapgate visible at toe.

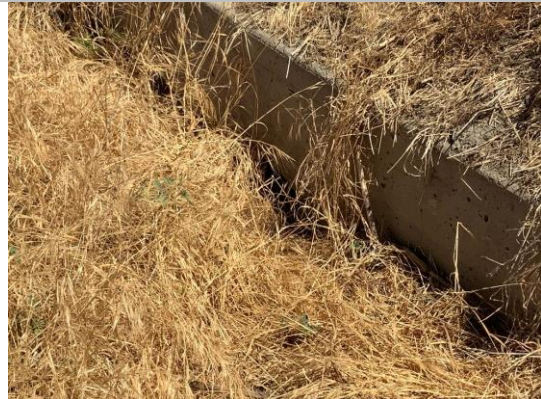
Photo 1 of 2 : UCIP_FA_2022_70954_100343.jpg

DS_ID:19675
 FS_ID:70954
 EP_NO: N/A
 Repair Type: Non-Urgent
 EVAL Issue: 11, Maintenance Compliance Issue
 Crossing Status: Found
 UCIP Comments: 06/7/2021 The record remains Non-Urgent. LS pipe inlet completely buried in dense vegetation, only top of headwall visible. Dense vegetation above WS flapgate. Limited inspection of pipe ends, recommend vegetation removal on both sides. No permit was found authorizing this encroachment. CVFPB will need to review crossing to determine owner. The UCIP inspection was completed with GEI staff, P. Espinoza. (H. Dunn – GEI) 05/14/2014 Dense vegetation on landward toe. Also dense vegetation limits the inspector's visibility to identify signs of pipe failure (leaks) along waterward slope. Recommend removing vegetation along pipe alignment toe to conduct proper inspection of structure. Sediment buildup in pipe--recommend clearing. (O. Magana - DWR UCIP)
 FIELD_STRUCT_DESC: 24-inch corrugated metal gravity drainage pipe (CMP) through the levee, 9.4 feet below the crown. Flap gate on the waterside (WS) end. Brass cap No. 120 bench mark (BM) on the headwall on the landside (LS). [Additional Reference(s): DWR Levee Log, 2002, (HLM 8.49). USACE San Joaquin O&M Manual, Unit No. 601, Part No. 1, 1967, Amended in 1978, Revised 20 June 1985, (HLM 8.48)].

LS view: Close up of pipe inlet, covered in vegetation.

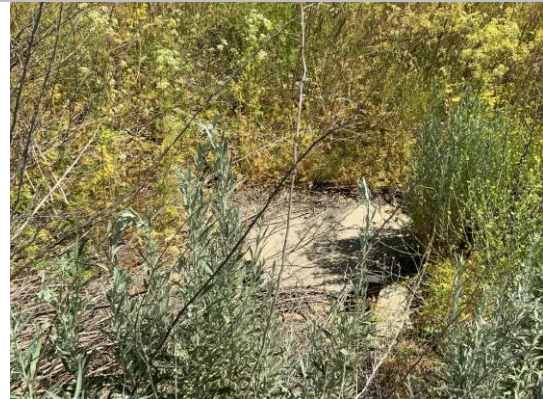
Photo 2 of 2 : UCIP_FA_2022_70954_100338.jpg

WS view: Top of flapgate visible at toe.

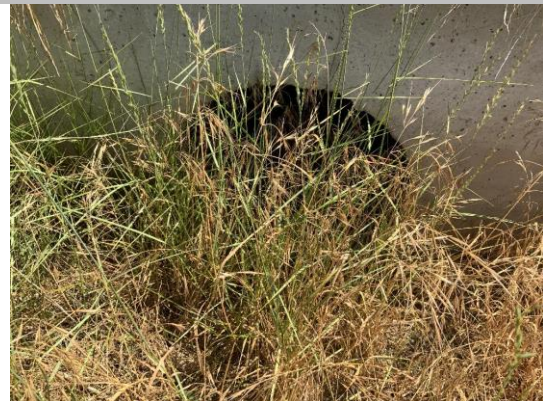
Photo 1 of 1 : UCIP_FA_2022_70955_100350.jpg

DS_ID:19676
 FS_ID:70955
 EP_NO: N/A
 Repair Type: Non-Urgent
 EVAL Issue: 11, Maintenance Compliance Issue
 Crossing Status: Found
 UCIP Comments: 06/7/2021 The record remains Non-Urgent. DWR DMP internal inspection has not found pipe integrity issues. LOF of crossing is less or equal to 4.0. Recommend next video inspection in 5 years. Dense vegetation around LS pipe end, recommend removal. No permit was found authorizing this encroachment. CVFPB will need to review crossing to determine owner. The UCIP inspection was completed with GEI staff, P. Espinoza. (H. Dunn – GEI) 05/14/2014 Dense vegetation limits the inspector's visibility to identify signs of pipe failure (leaks) along the slope. Recommend removing vegetation along pipe alignment to conduct proper inspection of structure. Burrow activity present on waterward slope. (O. Magana - DWR UCIP)
 FIELD_STRUCT_DESC: 24-inch corrugated metal gravity drainage pipe (CMP) through the levee, 8.8 feet below the crown. Flap gate on the waterside (WS) end. Brass cap No. 120 bench mark (BM) on the headwall on the landside (LS). [Additional Reference(s): DWR Levee Log, 2002, (HLM 8.88). USACE San Joaquin O&M Manual, Unit No. 601, Part No. 1, 1967, Amended in 1978, Revised 20 June 1985, (recorded as HLM 9.86, should be HLM 8.86)].

LS view: Close up of pipe inlet at toe.

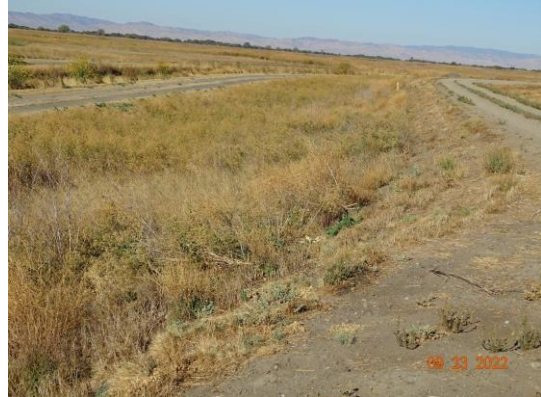
Photo 1 of 1 : FA_2022_NA0010_120_17_20221010_00044.jpg

LM Start	8.94	Rating **	M	Issue No.	17
LM End	9.23	Issue Type +	Ma	Location *	LS
Category	Earthen Levee			GPS Latitude/Longitude	
				Start	End
Item	Vegetation			37.221212 °	37.220375 °
				-120.797253 °	-120.792237 °
DWR ID	DWR_NA0010_02B_f_2022_17				
Comment Code					
V1 : Control annual grass and weeds on the levee slopes and easements.					
Inspector Comment

View of the landside slope looking downstream. (Fall 2022)

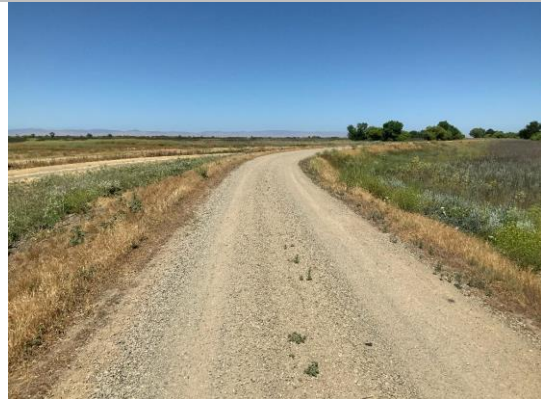
Photo 1 of 3 : UCIP_FA_2022_70956_100353.jpg

Comment Code					
Inspector Comment					
DS_ID:19677 FS_ID:70956 EP_NO: N/A Repair Type: Non-Urgent EVAL Issue: Crossing Status: Found UCIP Comments: 06/7/2021 The record remains Non-Urgent. No permit was found authorizing this encroachment. CVFPB will need to review crossing to determine owner. Minor vegetation over LS pipe inlet. The UCIP inspection was completed with GEI staff, P. Espinoza. (H. Dunn ? GEI) 05/14/201 Dense vegetation limits the inspector's visibility to identify signs of pipe failure (leaks) along the slope. Recommend removing vegetation along pipe alignment to conduct proper inspection of structure. (O. Magana - DWR UCIP) FIELD_STRUCT_DESC: 36-inch corrugated metal gravity drainage pipe (CMP) through the levee, 8.8 feet below the crown. Flap gate on the waterside (WS) end. Brass cap No. 120 bench mark (BM) on the headwall on the landside (LS). [Additional Reference(s): DWR Levee Log, 2002, (HLM 9.03). USACE San Joaquin O&M Manual, Unit No. 601, Part No. 1, 1967, Amended in 1978, Revised 20 June 1985, (HLM 9.02)]. FS Date: 6/7/2021

Levee crown looking downstream.

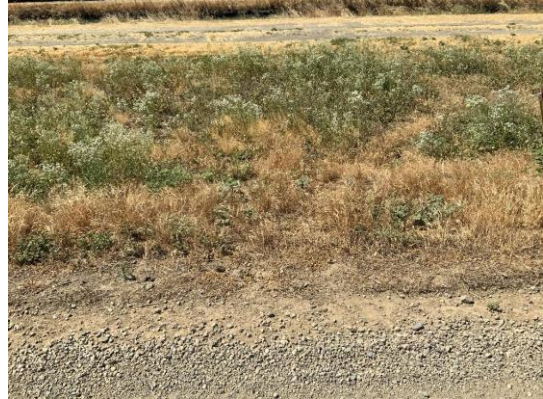
Photo 2 of 3 : UCIP_FA_2022_70956_100354.jpg

LS view: Toe from crown.

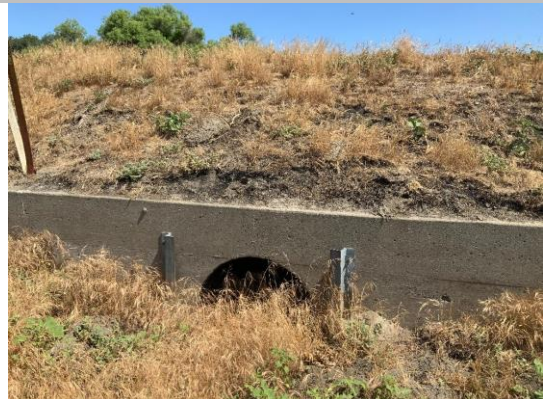
Photo 3 of 3 : UCIP_FA_2022_70956_100355.jpg

LS view: Slope and headwall at toe.

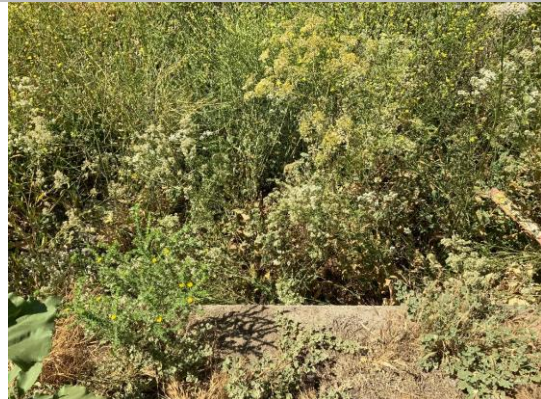
Photo 1 of 1 : UCIP_FA_2022_70957_100363.jpg

Comment Code						
Inspector Comment						
DS_ID:19678 FS_ID:70957 EP_NO: N/A Repair Type: Non-Urgent EVAL Issue: 11, Maintenance Compliance Issue Crossing Status: Found UCIP Comments: 06/7/2021 The record remains Non-Urgent. DWR DMP internal inspection has not found pipe integrity issues. LOF of crossing is less or equal to 4.0. Recommend next video inspection in 5 years. Dense vegetation over LS pipe inlet limited inspection, recommend removal. No permit was found authorizing this encroachment. CVFPB will need to review crossing to determine owner. The UCIP inspection was completed with GEI staff, P. Espinoza. (H. Dunn – GEI) 05/14/2014 Dense vegetation limits the inspector's visibility to identify signs of pipe failure (leaks) along the slope. Recommend removing vegetation along pipe alignment to conduct proper inspection of structure. (O. Magana - DWR UCIP) FIELD_STRUCT_DESC: 24-inch corrugated metal gravity drainage pipe (CMP) through the levee, 8.0 feet below the crown. Flap gate on the waterside (WS) end. Brass cap No. 120 bench mark (BM) on the headwall on the landside (LS). [Additional Reference(s): DWR Levee Log, 2002, (HLM 9.21). USACE San Joaquin O&M Manual, Unit No. 601, Part No. 1, 1967, Amended in 1978, Revised 20 June 1985, (HLM 9.20)]. FS Date: 6/7/2021

LS view: Top of headwall visible, pipe inlet covered with dense vegetation.

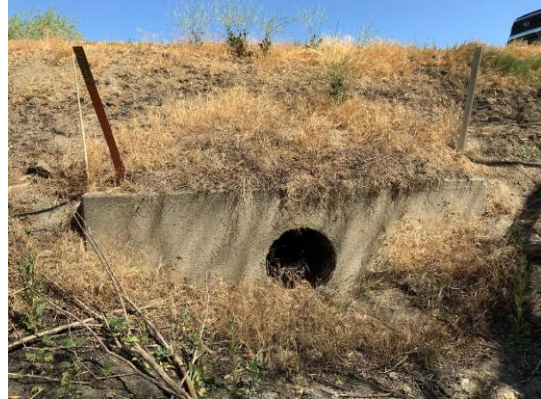
Photo 1 of 2 : UCIP_FA_2022_70958_100371.jpg

Comment Code						
Inspector Comment						
DS_ID:19686 FS_ID:70958 EP_NO: N/A Repair Type: Urgent EVAL Issue: 1, Pipe Integrity Crossing Status: Found UCIP Comments: 06/7/2021 The record has been upgraded from Non-Urgent to Urgent. DWR DMP internal inspection has found pipe integrity issues. LOF of crossing is greater than or equal to 5.0. Crossing will be monitored until funding becomes available to address the issues. Some rusting and peeling of liner inside LS pipe inlet. No permit was found authorizing this encroachment. CVFPB will need to review crossing to determine owner. The UCIP inspection was completed with GEI staff, P. Espinoza. (H. Dunn – GEI)05/14/2014 Dense vegetation limits the inspector's visibility to identify signs of pipe failure (leaks) along the slope. Recommend removing vegetation along pipe alignment to conduct proper inspection of structure. (O. Magana - DWR UCIP) FIELD_STRUCT_DESC: 24-inch corrugated metal gravity drainage pipe (CMP) through the levee, 9.0 feet below the crown. Flap gate on the waterside (WS) end. Brass cap No. 115 bench mark (BM) on the headwall on the landside (LS). [Additional Reference(s): DWR Levee Log, 2002, (HLM 9.47). USACE San Joaquin O&M Manual, Unit No. 601, Part No. 1, 1967, Amended in 1978, Revised 20 June 1985, (HLM 9.46)]. FS Date: 6/7/2021

LS view: Slope and headwall at toe.

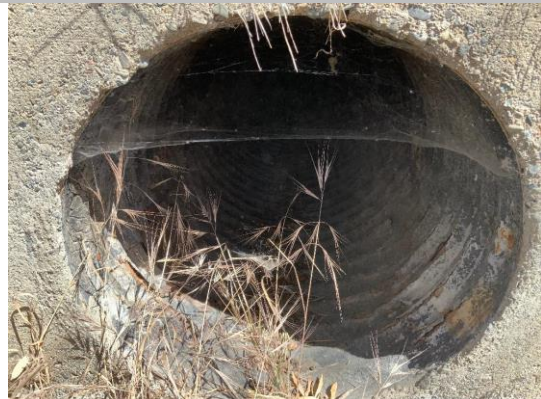
Photo 2 of 2 : UCIP_FA_2022_70958_100372.jpg

LS view: Close up of pipe inlet at toe.

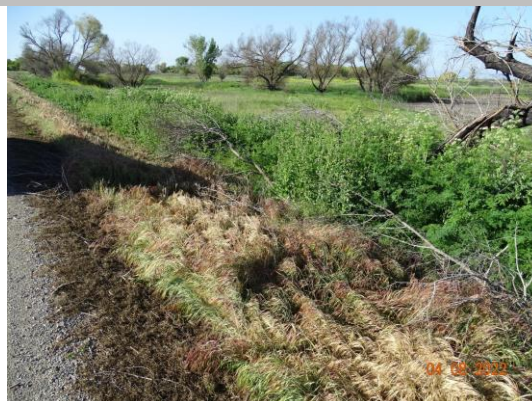
Photo 1 of 1 : FA_2022_NA0010_120_18_20220822_00004.jpg

LM Start	9.82	Rating **	M	Issue No.	18
LM End	9.82	Issue Type +	Ma	Location *	LS
Category	Earthen Levee			GPS Latitude/Longitude	
				Start	End
Item	Trim / Thin Trees			37.218056 °	37.218056 °
				-120.784200 °	-120.784200 °
DWR ID	DWR_NA0010_02B_s_2022_18				
Comment Code					
T3 : Fallen tree with root ball.					
Inspector Comment

Fallen tree branches on the landside slope. (Spring 2022)

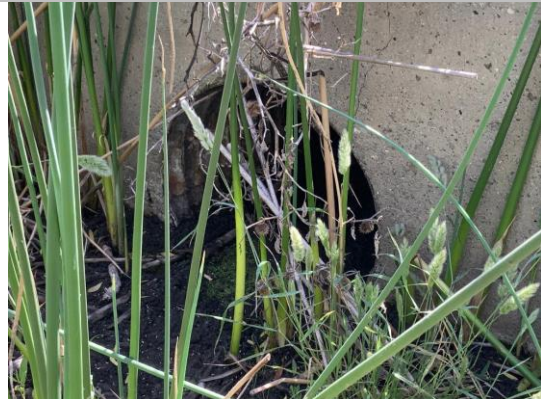
Photo 1 of 2 : UCIP_FA_2022_70959_100379.jpg

Comment Code						
Inspector Comment						
DS_ID:19687 FS_ID:70959 EP_NO: N/A Repair Type: Non-Urgent EVAL Issue: 11, Maintenance Compliance Issue Crossing Status: Found UCIP Comments: 06/7/2021 The record remains Non-Urgent. Some sediment buildup inside LS pipe inlet. LS pipe inlet also covered by some vegetation. Recommend cleaning out sediment and removing vegetation. WS flapgate partially underwater and covered by vegetation, limited inspection of both WS and LS. No permit was found authorizing this encroachment. CVFPB will need to review crossing to determine owner. The UCIP inspection was completed with GEI staff, P. Espinoza. (H. Dunn- GEI) 05/14/2014 Dense vegetation limits the inspector's visibility to identify signs of pipe failure (leaks) along the slope. Recommend removing vegetation along pipe alignment to conduct proper inspection of structure. (O. Magana - DWR UCIP) FIELD_STRUCT_DESC: 24-inch corrugated metal gravity drainage pipe (CMP) through the levee, 11.7 feet below the crown. Flap gate on the waterside (WS) end. Brass cap No. 115 bench mark (BM) on the headwall on the landside (LS). [Additional Reference(s): DWR Levee Log, 2002, (HLM 10.13). USACE San Joaquin O&M Manual, Unit No. 601, Part No. 1, 1967, Amended in 1978, Revised 20 June 1985, (HLM 10.12)]. FS Date: 6/7/2021

LS view: Close up of pipe inlet at toe, sediment built up.

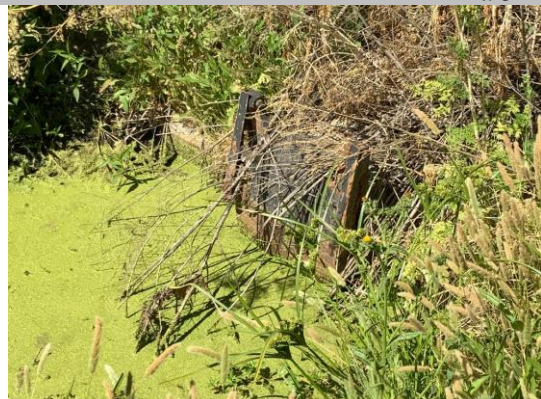
Photo 2 of 2 : UCIP_FA_2022_70959_100374.jpg

WS view: Close up of flapgate partially underwater at toe.

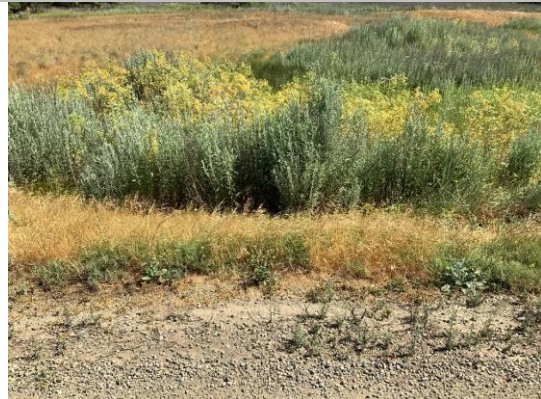
Photo 1 of 2 : UCIP_FA_2022_70960_100381.jpg

Comment Code						
Inspector Comment						
DS_ID:19688 FS_ID:70960 EP_NO: N/A Repair Type: Non-Urgent EVAL Issue: 11, Maintenance Compliance Issue Crossing Status: Found UCIP Comments: 06/7/2021 The record remains Non-Urgent. WS end and flapgate is overgrown with dense vegetation limiting inspection, recommend removal. No permit was found authorizing this encroachment. CVFPB will need to review crossing to determine owner. The UCIP inspection was completed with GEI staff, P. Espinoza. (H. Dunn – GEI) 05/14/2014 Dense vegetation limits the inspector's visibility to identify signs of pipe failure (leaks) along the slope. Recommend removing vegetation along pipe alignment to conduct proper inspection of structure. Sediment buildup in pipe visible on landward side--recommend clearing. (O. Magana - DWR UCIP) FIELD_STRUCT_DESC: 24-inch corrugated metal gravity drainage pipe (CMP) through the levee, 8.0 feet below the crown. Flap gate on the waterside (WS) end. Brass cap No. 115 bench mark (BM) on the headwall on the landside (LS). [Additional Reference(s): DWR Levee Log, 2002, (HLM 10.82). USACE San Joaquin O&M Manual, Unit No. 601, Part No. 1, 1967, Amended in 1978, Revised 20 June 1985, (HLM 10.81)]. FS Date: 6/7/2021

WS view: Toe from crown.

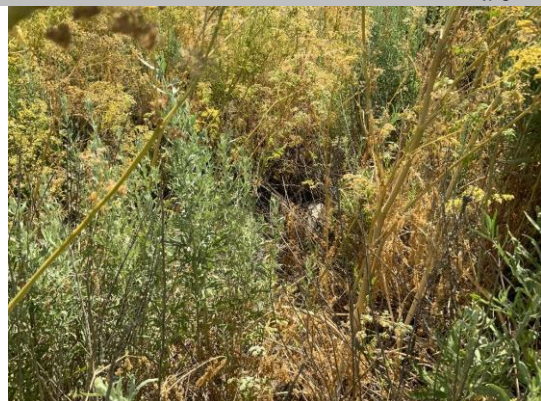
Photo 2 of 2 : UCIP_FA_2022_70960_100382.jpg

WS view: Dense vegetation covering flapgate at toe.

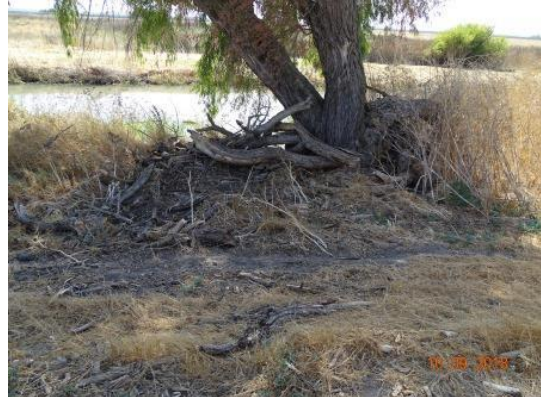
Photo 1 of 1 : FA_2022_NA0010_120_14_20220822_00002.jpg

Prunings at landside toe. (Fall 2018)

LM Start	10.94	Rating **	M	Issue No.	14
LM End	10.94	Issue Type +	Ma	Location *	LS
Category	Earthen Levee			GPS Latitude/Longitude	
				Start	End
Item	Encroachments			37.205711 °	37.205711 °
				-120.774741 °	-120.774741 °
DWR ID	DWR_NA0010_02B_f_2015_14				
Comment Code					
PR : Prunings					
Inspector Comment					
Remove prunings from landside toe.

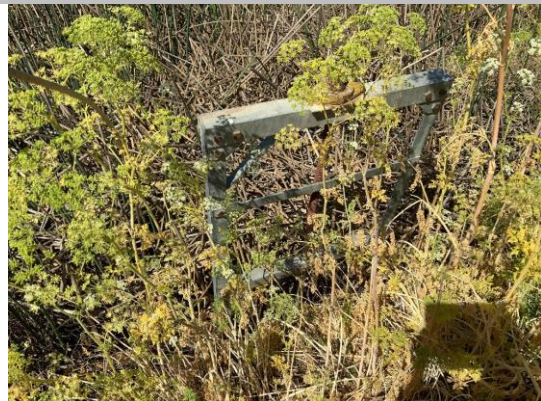
Photo 1 of 1 : UCIP_FA_2022_70961_100390.jpg

Comment Code						
Inspector Comment						
DS_ID:19689 FS_ID:70961 EP_NO: N/A Repair Type: Non-Urgent EVAL Issue: 11, Maintenance Compliance Issue Crossing Status: Found UCIP Comments: 06/7/2021 The record remains Non-Urgent. Dense vegetation covering LS pipe inlet limiting inspection, recommend removal. No permit was found authorizing this encroachment. CVFPB will need to review crossing to determine owner. The UCIP inspection was completed with GEI staff, P. Espinoza. (H. Dunn- GEI) 05/14/201 Dense vegetation limits the inspector's visibility to identify signs of pipe failure (leaks) along the slope. Recommend removing vegetation along pipe alignment to conduct proper inspection of structure. (O. Magana - DWR UCIP) FIELD_STRUCT_DESC: 24-inch corrugated metal gravity drainage pipe (CMP) through the levee, 8.0 feet below the crown. Flap gate on the waterside (WS) end. Brass cap No. 115 bench mark (BM) on the headwall on the landside (LS). [Additional Reference(s): DWR Levee Log, 2002, (HLM 11.18). USACE San Joaquin O&M Manual, Unit No. 601, Part No. 1, 1967, Amended in 1978, Revised 20 June 1985, (HLM 11.17)]. FS Date: 6/7/2021

LS view: Headwall barely visible at toe, inlet covered in vegetation.

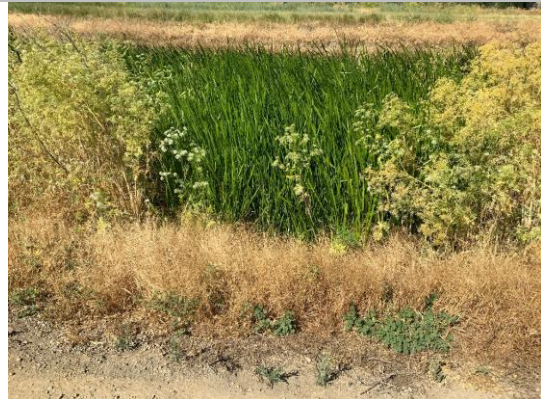
Photo 1 of 2 : UCIP_FA_2022_70962_100395.jpg

DS_ID:19690
FS_ID:70962
EP_NO: N/A
Repair Type: Non-Urgent
EVAL Issue: 11, Maintenance Compliance Issue
Crossing Status: Found
UCIP Comments: 06/7/2021 The record remains Non-Urgent. Dense vegetation over LS end, cannot see pipe inlet, recommend vegetation removal. WS flapgate has some vegetation covering it, recommend clearing. No permit was found authorizing this encroachment. CVFPB will need to review crossing to determine owner. The UCIP inspection was completed with GEI staff, P. Espinoza. (H. Dunn – GEI)

LS view: Toe from crown, dense vegetation, no pipe visible.

05/14/2014 Dense vegetation limits the inspector's visibility to identify signs of pipe failure (leaks) along the slope. Recommend removing vegetation along pipe alignment to conduct proper inspection of structure. (O. Magana - DWR UCIP)

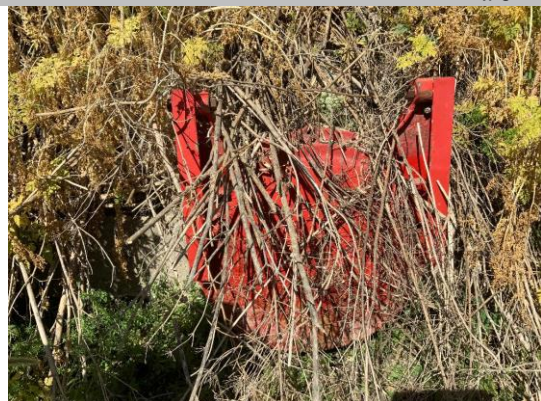
Photo 2 of 2 : UCIP_FA_2022_70962_100398.jpg

WS view: Close up of flapgate at toe.

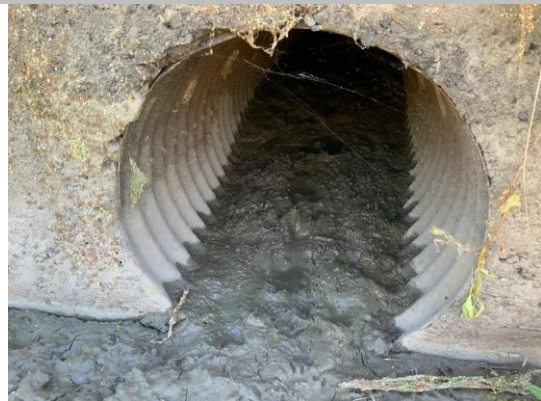
Photo 1 of 2 : UCIP_FA_2022_70963_100404.jpg

Comment Code					
Inspector Comment					
DS_ID:19663 FS_ID:70963 EP_NO: N/A Repair Type: Non-Urgent EVAL Issue: 11, Maintenance Compliance Issue Crossing Status: Found UCIP Comments: 06/7/2021 The record remains Non-Urgent. Sediment buildup inside LS pipe inlet, recommend cleaning out. Dense vegetation over WS end limited inspection, recommend removal. No permit was found authorizing this encroachment. CVFPB will need to review crossing to determine owner. The UCIP inspection was completed with GEI staff, P. Espinoza. (H. Dunn - GEI) 05/14/201 Dense vegetation limits the inspector's visibility to identify signs of pipe failure (leaks) along the slope. Recommend removing vegetation along pipe alignment to conduct proper inspection of structure. Sediment buildup in pipe-- recommend clearing. (O. Magana - DWR UCIP) FIELD_STRUCT_DESC: 24-inch corrugated metal gravity drainage pipe (CMP) through the levee, 6.5 feet below the crown. Slide gate in a pipe riser unit on the waterside (WS) slope. [Additional Reference(s): DWR Levee Log, 2002, (HLM 13.23). USACE San Joaquin O&M Manual, Unit No. 601, Part No. 1, 1967, Amended in 1978, Revised 20 June 1985, (HLM 13.22)]. FS Date: 6/7/2021

LS view: Close up of pipe inlet at toe, sediment buildup.

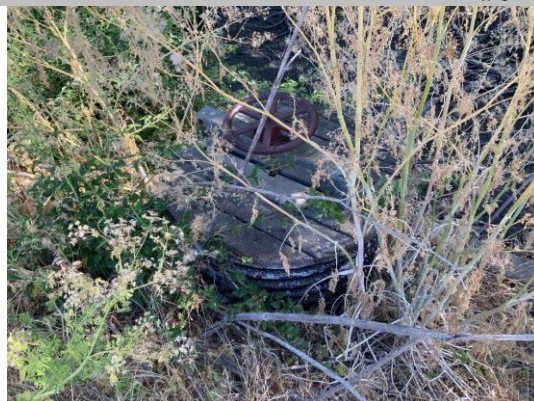
Photo 2 of 2 : UCIP_FA_2022_70963_100399.jpg

WS view: Close up of riser with slidegate on slope.

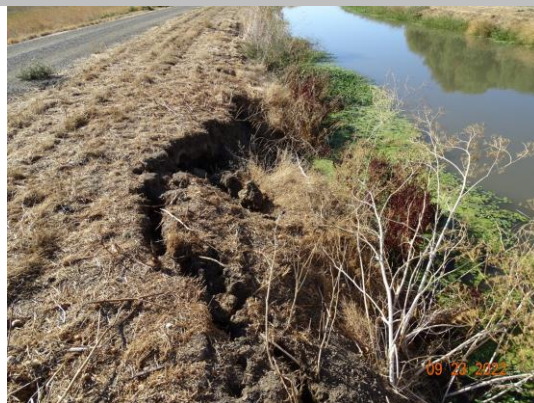
Photo 1 of 1 : FA_2022_NA0010_120_16_20221010_00045.jpg

Erosion pocket on the landside slope. (Fall 2022)

LM Start	13.54	Rating **	M	Issue No.	16
LM End	13.54	Issue Type +	Ma	Location *	LS
Category	Earthen Levee			GPS Latitude/Longitude	
				Start	End
Item	Erosion / Bank Caving			37.175195 °	37.175195 °
				-120.761033 °	-120.761033 °
DWR ID	DWR_NA0010_02B_f_2022_16				
Comment Code					
E2 : Schedule repair of erosion site prior to the next inspection.					
Inspector Comment

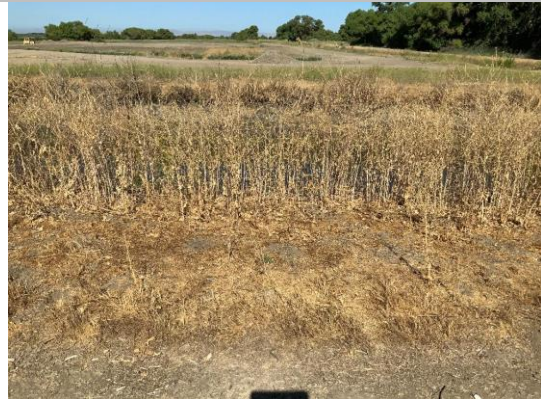
Photo 1 of 2 : UCIP_FA_2022_70964_100407.jpg

Comment Code					
Inspector Comment					
DS_ID:19664 FS_ID:70964 EP_NO: 14138 Repair Type: Non-Urgent EVAL Issue: 11, Maintenance Compliance Issue Crossing Status: Not Found UCIP Comments: 06/7/2021 The record remains Non-Urgent. Pipe not found by visual inspection. Dense vegetation on either side, no pipe visible. Recommend removing vegetation to assess if pipe is there. The UCIP inspection was completed with GEI staff, P. Espinoza. (H. Dunn - GEI)05/14/201 Dense vegetation limits the inspector's visibility to identify signs of pipe failure (leaks) along the slope. Recommend removing vegetation along pipe alignment to conduct proper inspection of structure. (O. Magana - DWR UCIP) FIELD_STRUCT_DESC: 24-inch corrugated metal gravity drainage pipe (CMP) through the levee, 10.0 feet below the crown. Concrete cutoff wall at the center of the levee. Flap gate on the landside (LS) end. Screw gate on the waterside (WS) end with accessible walkway. (24-inch reinforced concrete [RC] pipe authorized under Permit No. 14138, 1985 - United States Fish and Wildlife Service). [Additional Reference(s): DWR Levee Log, 2002, (HLM 13.71)]. FS Date: 6/7/2021

LS view: Toe from crown, pipe not visible.

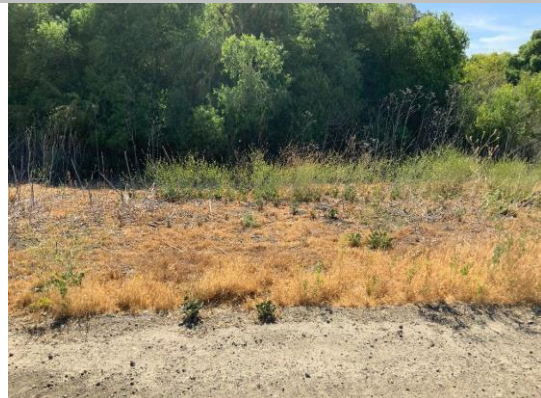
Photo 2 of 2 : UCIP_FA_2022_70964_100406.jpg

WS view: Toe from crown, pipe not visible.

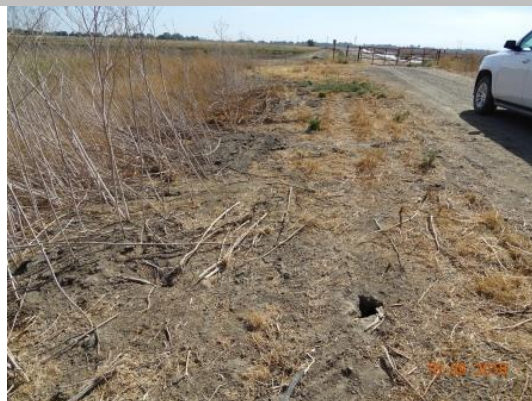
Photo 1 of 1 : FA_2022_NA0010_120_22_20220822_00006.jpg

LM Start	13.73	Rating **	M	Issue No.	22
LM End	13.73	Issue Type +	Ma	Location *	WS
Category	Earthen Levee			GPS Latitude/Longitude	
				Start	End
Item	Animal Control			37.172387 °	37.172387 °
				-120.761190 °	-120.761190 °
DWR ID	DWR_NA0010_02B_f_2018_22				
Comment Code					
A1 : Exterminate rodents and backfill and compact or grout burrows.					
Inspector Comment					
There are several rodent burrows observed at this location.

View of waterside slope looking upstream. (Fall 2018)

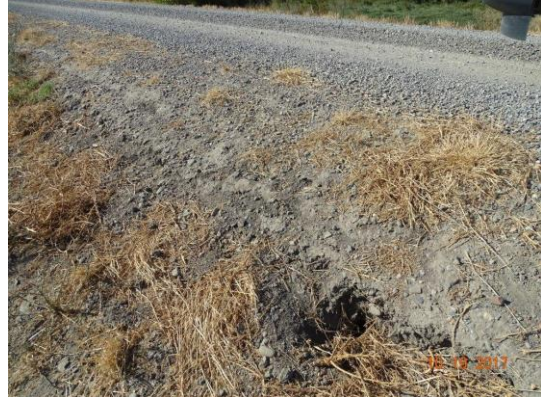
Photo 1 of 1 : FA_2022_NA0010_121_67_20220822_00009.jpg

LM Start	0.19	Rating **	M	Issue No.	67
LM End	0.19	Issue Type +	Ma	Location *	LS
Category	Earthen Levee			GPS Latitude/Longitude	
				Start	End
Item	Animal Control			37.109013 °	37.109013 °
				-120.587799 °	-120.587799 °
DWR ID	DWR_NA0010_03_s_2015_67				
Comment Code					
A3 : No rodents visible, but rodent burrows visible; need to backfill and compact or grout burrows.					
Inspector Comment					
Rodent holes are noted on the landside slope.

Looking southwest at the landside shoulder.

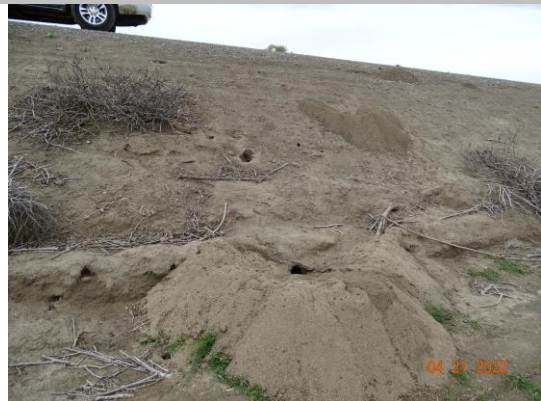
Photo 1 of 1 : FA_2022_NA0010_121_11_20220822_00005.jpg

LM Start	0.31	Rating **	U	Issue No.	11
LM End	0.31	Issue Type +	Ma	Location *	LS
Category	Earthen Levee			GPS Latitude/Longitude	
				Start	End
Item	Animal Control			37.107440 °	37.107440 °
				-120.587005 °	-120.587005 °
DWR ID	DWR_NA0010_03_s_2022_11				
Comment Code					
A3 : No rodents visible, but rodent burrows visible; need to backfill and compact or grout burrows.					
Inspector Comment					
Large amount of material displaced on the landside toe.

View of several rodent holes with large amounts of material displaced.
(Spring 2022)

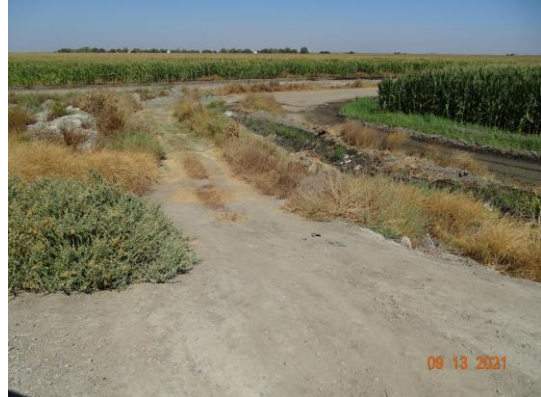
Photo 1 of 1 : FA_2022_NA0010_121_6_20220822_00002.jpg

LM Start	0.43	Rating **	M	Issue No.	6
LM End	0.43	Issue Type +	En	Location *	LS
Category	Earthen Levee			GPS Latitude/Longitude	
				Start	End
Item	Encroachments			37.106121 °	37.106121 °
				-120.585680 °	-120.585680 °
DWR ID	DWR_NA0010_03_f _ 2017_6				
Comment Code					
RA : Ramp					
Inspector Comment

Looking east at the landside slope. (Fall 2021)

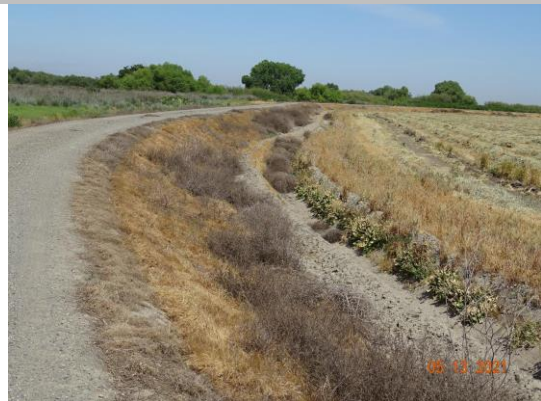
Photo 1 of 1 : FA_2022_NA0010_121_13_20220822_00007.jpg

LM Start	0.43	Rating **	M	Issue No.	13
LM End	2.02	Issue Type +	En	Location *	LS
Category	Earthen Levee			GPS Latitude/Longitude	
				Start	End
Item	Encroachments			37.106072 °	37.089499 °
				-120.585636 °	-120.568041 °
DWR ID	DWR_NA0010_03_s_2021_13				
Comment Code					
DT : Ditch					
Inspector Comment					
Landowner has dug a ditch in the landside toe. Landowner appears to be in the process of relocating the ditch away from the toe.

View of ditch dug on the landside toe. (Spring 2021)

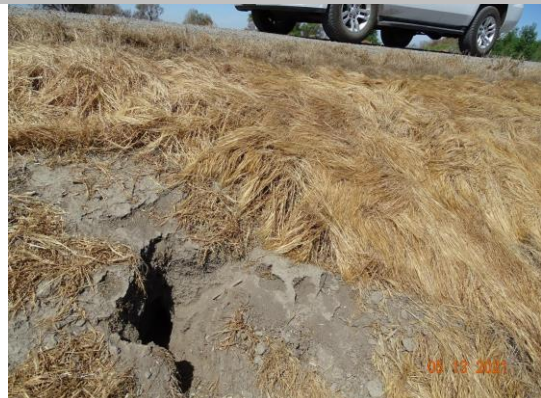
Photo 1 of 1 : FA_2022_NA0010_121_10_20220822_00004.jpg

LM Start	0.57	Rating **	U	Issue No.	10
LM End	0.57	Issue Type +	Ma	Location *	LS
Category	Earthen Levee			GPS Latitude/Longitude	
				Start	End
Item	Animal Control			37.104343 °	37.104343 °
				-120.584348 °	-120.584348 °
DWR ID	DWR_NA0010_03_s_2021_10				
Comment Code					
A3 : No rodents visible, but rodent burrows visible; need to backfill and compact or grout burrows.					
Inspector Comment

Several large rodent burrows observed at this location. (Spring 2021)

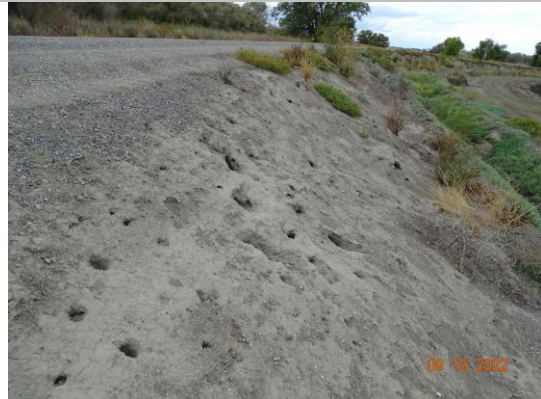
Photo 1 of 1 : FA_2022_NA0010_121_15_20221010_00022.jpg

LM Start	0.58	Rating **	M	Issue No.	15
LM End	0.85	Issue Type +	Ma	Location *	LS
Category	Earthen Levee			GPS Latitude/Longitude	
				Start	End
Item	Animal Control			37.104260 °	37.101912 °
				-120.584274 °	-120.580490 °
DWR ID	DWR_NA0010_03_s_2021_15				
Comment Code					
A1 : Exterminate rodents and backfill and compact or grout burrows.					
Inspector Comment

View of rodent holes on the landside slope. (Fall 2022)

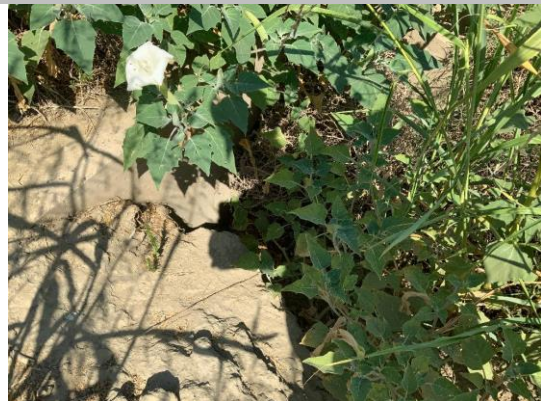
Photo 1 of 2 : UCIP_FA_2022_70966_101351.jpg

Comment Code						
Inspector Comment						
DS_ID:19692 FS_ID:70966 EP_NO: N/A Repair Type: Non-Urgent EVAL Issue: 11, Maintenance Compliance Issue Crossing Status: Found UCIP Comments: 07/12/2021 The record has been upgraded from No Action Needed to Non-Urgent. Dense vegetation over LS pipe inlet, headwall barely visible. Minor vegetation on WS, recommend removal on both ends. No permit was found authorizing this encroachment. CVFPB will need to review crossing to determine owner. The UCIP inspection was completed with GEI staff, P. Espinoza. (H. Dunn – GEI) FIELD_STRUCT_DESC: 24-inch corrugated metal gravity drainage pipe (CMP) through the levee, 9.3 feet below the crown. Flap gate on the waterside (WS) end. [Additional Reference(s): DWR Levee Log, 2002, (HLM 0.78). USACE San Joaquin O&M Manual, Unit No. 601, Part No. 1, 1967, Amended in 1978, Revised 20 June 1985, (HLM 0.77). DWR As-Built Specification No. 62-03, Sheet No. 10, 18 June 1962, (HLM 0.77)]. FS Date: 7/12/2021

LS view: Pipe inlet and headwall covered in vegetation.

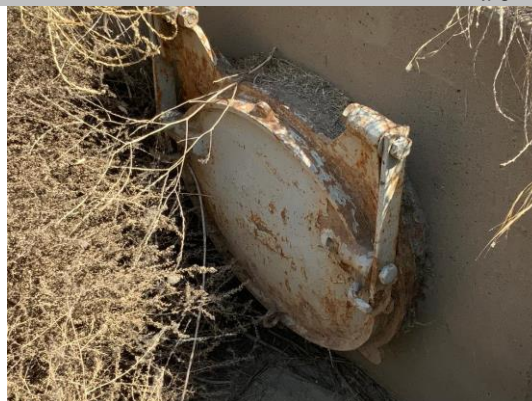
Photo 2 of 2 : UCIP_FA_2022_70966_101353.jpg

WS view: Closeup of flapgate at toe.

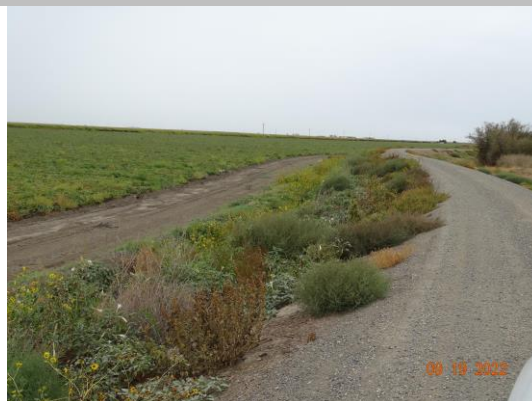
Photo 1 of 1 : FA_2022_NA0010_121_7_20221010_00023.jpg

LM Start	0.80	Rating **	M	Issue No.	7
LM End	2.03	Issue Type +	Ma	Location *	LS
Category	Earthen Levee			GPS Latitude/Longitude	
				Start	End
Item	Vegetation			37.102506 °	37.089456 °
				-120.580994 °	-120.567887 °
DWR ID	DWR_NA0010_03_f_2022_7				
Comment Code					
V1 : Control annual grass and weeds on the levee slopes and easements.					
Inspector Comment

View of vegetation growing on the landside slope. (Fall 2022)

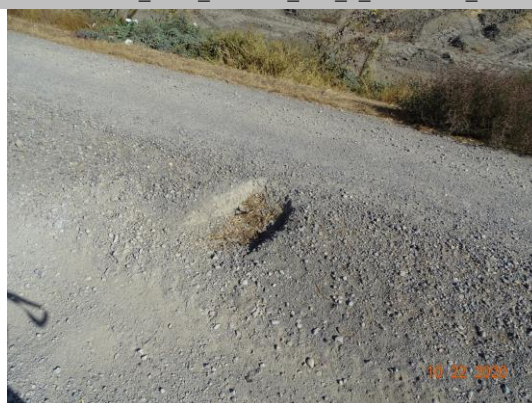
Photo 1 of 1 : FA_2022_NA0010_121_8_20220822_00003.jpg

LM Start	0.86	Rating **	M	Issue No.	8
LM End	0.86	Issue Type +	Ma	Location *	CR
Category	Earthen Levee			GPS Latitude/Longitude	
				Start	End
Item	Animal Control			37.101821 °	37.101821 °
				-120.580358 °	-120.580358 °
DWR ID	DWR_NA0010_03_f_2020_8				
Comment Code					
A3 : No rodents visible, but rodent burrows visible; need to backfill and compact or grout burrows.					
Inspector Comment

Depression in the levee crown from rodent activity. (Fall 2020)

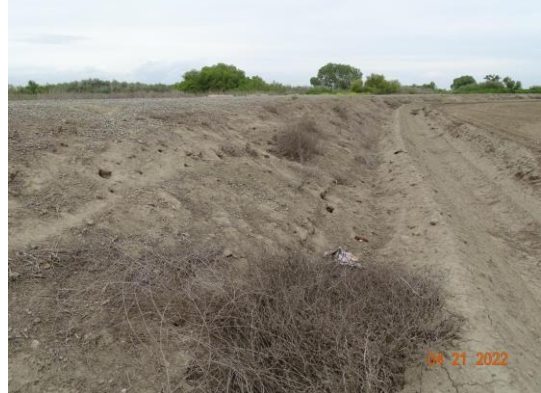
Photo 1 of 1 : FA_2022_NA0010_121_12_20220822_00006.jpg

LM Start	1.70	Rating **	M	Issue No.	12
LM End	1.78	Issue Type +	Ma	Location *	LS
Category	Earthen Levee			GPS Latitude/Longitude	
				Start	End
Item	Animal Control			37.092231 °	37.091302 °
				-120.572337 °	-120.571632 °
DWR ID	DWR_NA0010_03_f _ 2020_12				
Comment Code					
A1 : Exterminate rodents and backfill and compact or grout burrows.					
Inspector Comment

View of several animal holes in the landside slope. (Spring 2022)

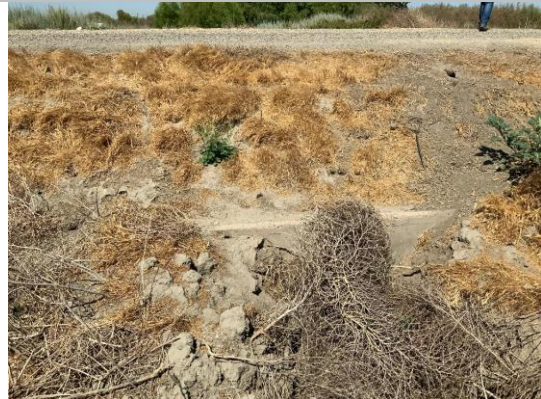
Photo 1 of 2 : UCIP_FA_2022_70967_101359.jpg

Comment Code						
Inspector Comment						
DS_ID:19693 FS_ID:70967 EP_NO: N/A Repair Type: Non-Urgent EVAL Issue: 11, Maintenance Compliance Issue Crossing Status: Found UCIP Comments: 07/12/2021 The record remains Non-Urgent. There is dense vegetation over LS pipe inlet and WS flapgate, recommend removal. No permit was found authorizing this encroachment. CVFPB will need to review crossing to determine owner. The UCIP inspection was completed with GEI staff, P. Espinoza. (H. Dunn – GEI) 04/17/2014 Sediment buildup in pipe visible from landward side-- recommend clearing. (O. Magana - DWR UCIP) FIELD_STRUCT_DESC: 24-inch corrugated metal gravity drainage pipe (CMP) through the levee, 6.8 feet below the crown. Flap gate on the waterside (WS) end. [Additional Reference(s): DWR Levee Log, 2002, (HLM 1.73). USACE San Joaquin O&M Manual, Unit No. 601, Part No. 1, 1967, Amended in 1978, Revised 20 June 1985, (HLM 1.72). DWR As-Built Specification No. 62-03, Sheet No. 11, 18 June 1962, (HLM 1.72)]. FS Date: 7/12/2021

LS view: Slope and headwall from toe.

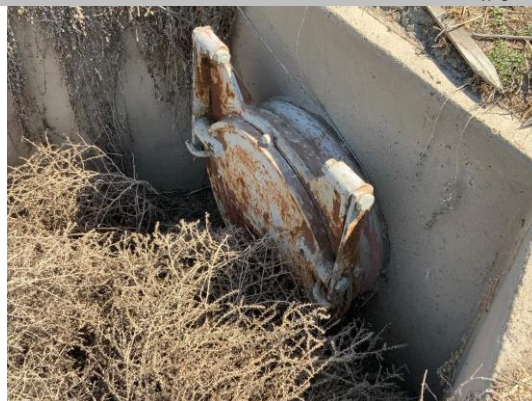
Photo 2 of 2 : UCIP_FA_2022_70967_101356.jpg

WS view: Close up of flapgate at toe.

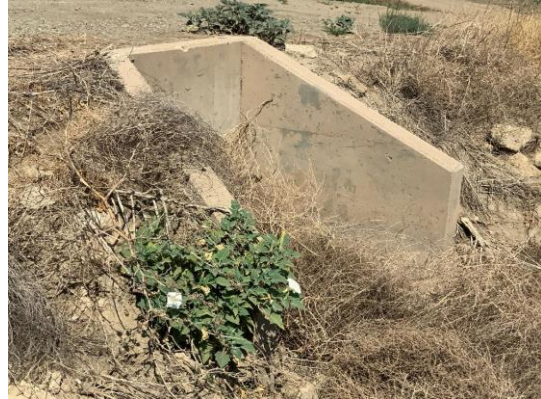
Photo 1 of 2 : UCIP_FA_2022_70968_101364.jpg

Comment Code					
Inspector Comment					
DS_ID:19694 FS_ID:70968 EP_NO: N/A Repair Type: Non-Urgent EVAL Issue: 11, Maintenance Compliance Issue Crossing Status: Found UCIP Comments: 07/12/2021 The record remains Non-Urgent. Dense vegetation over WS and LS inlet/outlet, recommend removal. As mentioned in the previous inspection, there is a 16 inch metal pipe directly opposite the WS pipe slidegate/outlet that goes just underground and out through to the channel. Recommend contacting owner for more information on these WS appurtenances. No permit was found authorizing this encroachment. CVFPB will need to review crossing to determine owner. The UCIP inspection was completed with GEI staff, P. Espinoza. (H. Dunn ? GEI) 04/17/2014 Need to contact owner--additional appurtenances found on waterward side not part of original description. Unable to determine if walkway, pump, and pipe through waterward berm is if part of original crossing. (O. Magana - DWR UCIP) FIELD_STRUCT_DESC: 36-inch corrugated metal irrigation discharge pipe (CMP) through the levee, 6.6 feet below the crown. Pump on the riverbank. Slide gate on the waterside (WS) end. [Additional Reference(s): DWR Levee Log, 2002, (HLM 2.05). USACE San Joaquin O&M Manual, Unit No. 601, Part No. 1, 1967, Amended in 1978, Revised 20 June 1985, (HLM 2.05). DWR As-Built Specification No. 62-03, Sheet No. 11, 18 June 1962, (HLM 2.05)]. FS Date: 7/12/2021

LS view: Headwall and inlet covered with tumbleweeds.

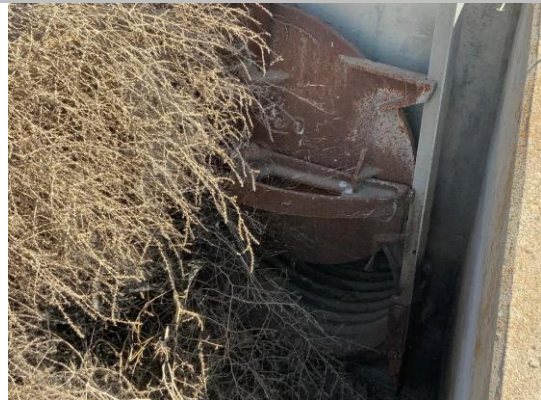
Photo 2 of 2 : UCIP_FA_2022_70968_101368.jpg

WS view: Closeup of slidegate at toe.

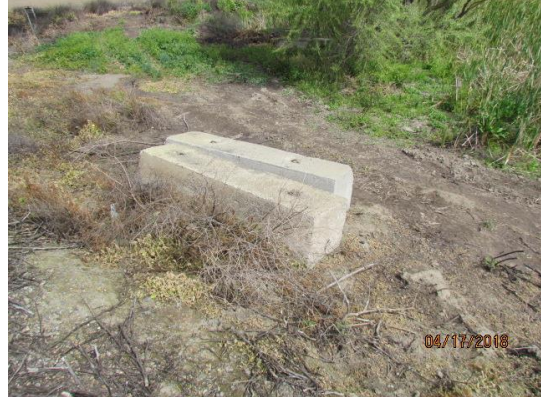
Photo 1 of 1 : FA_2022_NA0010_121_5_20220822_00001.jpg

LM Start	2.05	Rating **	U	Issue No.	5
LM End	2.05	Issue Type +	En	Location *	LS
Category	Earthen Levee			GPS Latitude/Longitude	
				Start	End
Item	Encroachments			37.089289 °	37.089289 °
				-120.567463 °	-120.567463 °
DWR ID	DWR_NA0010_03_s_2018_5				
Comment Code					
MA : Material					
Inspector Comment					
Two large concrete blocks are located on the landward toe.

Looking southwest at concrete blocks on landward toe. (Spring 2018)

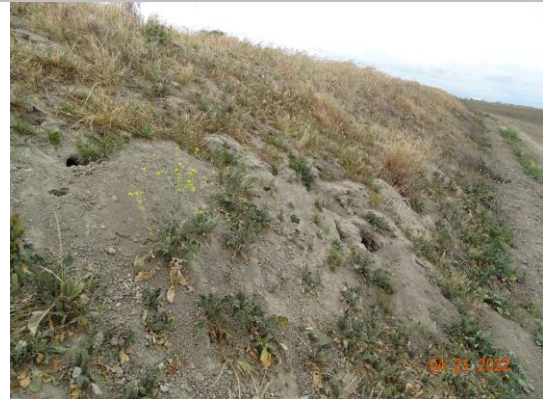
Photo 1 of 1 : FA_2022_NA0010_122_10_20220822_00002.jpg

LM Start	0.10	Rating **	M	Issue No.	10
LM End	0.10	Issue Type +	Ma	Location *	LS
Category	Earthen Levee			GPS Latitude/Longitude	
				Start	End
Item	Animal Control			37.111692 °	37.111692 °
				-120.590312 °	-120.590312 °
DWR ID	DWR_NA0010_04_s_2022_10				
Comment Code					
A1 : Exterminate rodents and backfill and compact or grout burrows.					
Inspector Comment

View of rodent holes on the landside slope. (Spring 2022)

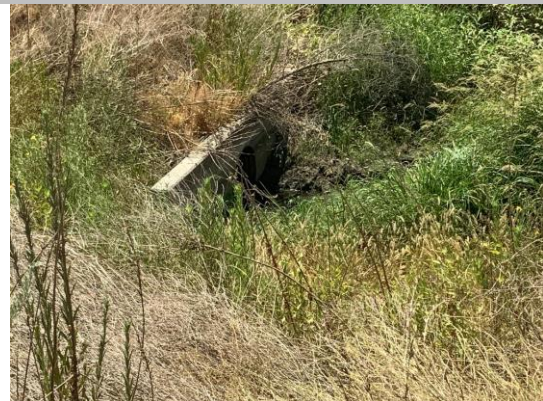
Photo 1 of 2 : UCIP_FA_2022_70974_101406.jpg

Comment Code						
Inspector Comment						
DS_ID:19695 FS_ID:70974 EP_NO: N/A Repair Type: Non-Urgent EVAL Issue: 11, Maintenance Compliance Issue Crossing Status: Found UCIP Comments: 07/12/2021 The record remains Non-Urgent. WS flapgate is underwater and covered by vegetation. LS inlet also covered by vegetation, recommend removal on both ends. No permit was found authorizing this encroachment. CVFPB will need to review crossing to determine owner. The UCIP inspection was completed with GEI staff, P. Espinoza. (H. Dunn – GEI) 04/17/2014 Sediment and debris blocking concrete headwall located on waterward side. During inspection water was flowing from landward side to waterward side. Recommend removing sediment to confirm condition of flap gate and pipe. (O. Magana - DWR UCIP) FIELD_STRUCT_DESC: 36-inch corrugated metal gravity drainage pipe (CMP) through the levee, 18.0 feet below the crown. Flap gate on the waterside (WS) end. Concrete headwall on each end. [Additional Reference(s): DWR Levee Log, 2002, (HLM 0.24). USACE San Joaquin O&M Manual, Unit No. 601, Part No. 1, 1967, Amended in 1978, Revised 20 June 1985, (HLM 0.27)]. FS Date: 7/12/2021

LS view: Pipe inlet with water in it at toe.

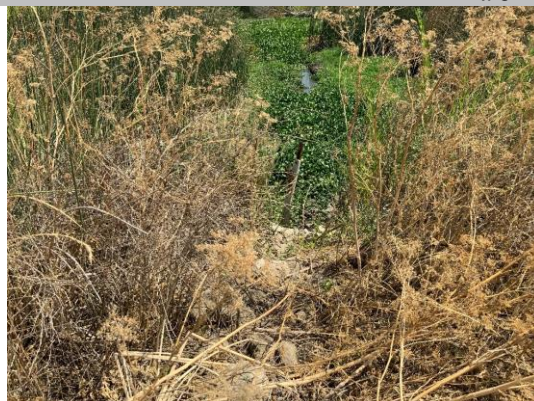
Photo 2 of 2 : UCIP_FA_2022_70974_101408.jpg

WS view: Pipe and flapgate not visible due to dense vegetation and water.

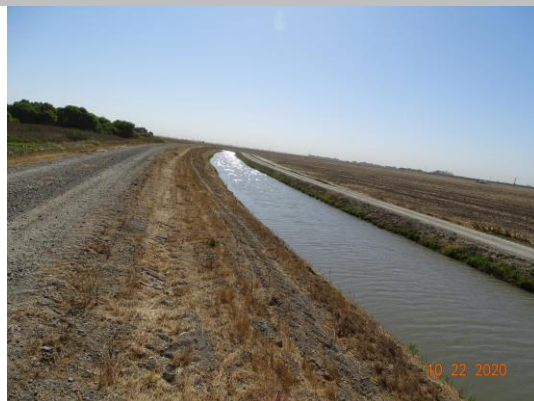
Photo 1 of 1 : FA_2022_NA0010_122_3_20220822_00001.jpg

LM Start	0.32	Rating **	A/W	Issue No.	3
LM End	1.41	Issue Type +	En	Location *	LS
Category	Earthen Levee			GPS Latitude/Longitude	
				Start	End
Item	Encroachments			37.108822 °	37.097556 °
				-120.590718 °	-120.578130 °
DWR ID	DWR_NA0010_04_s_2012_3				
Comment Code					
DT : Ditch					
Inspector Comment					
An irrigation ditch is within 10' easement. Shown on the as-built drawings.

Looking upstream at an irrigation ditch at the landside toe. (Fall 2020)

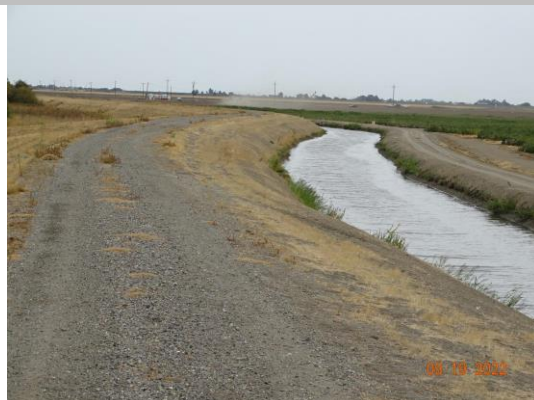
Photo 1 of 1 : FA_2022_NA0010_122_8_20221010_00021.jpg

LM Start	0.32	Rating **	A	Issue No.	8
LM End	0.32	Issue Type +	Ma	Location *	LS
Category	Earthen Levee			GPS Latitude/Longitude	
				Start	End
Item	Vegetation			37.108762 °	37.108762 °
				-120.590714 °	-120.590714 °
DWR ID	DWR_NA0010_04_f_2022_8				
Comment Code					
V1 : Control annual grass and weeds on the levee slopes and easements.					
Inspector Comment					
The annual vegetation is well maintained.

View of vegetation control on the landside slope. (Fall 2022)

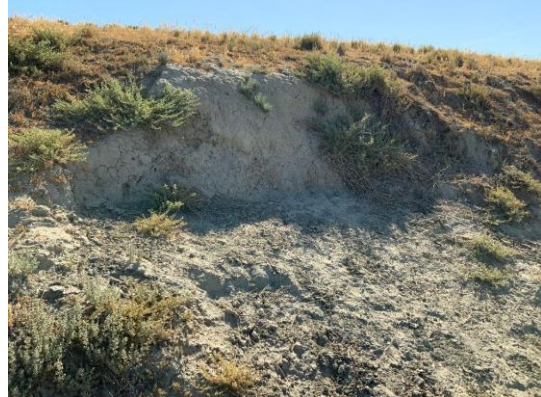
Photo 1 of 2 : UCIP_FA_2022_70983_99632.jpg

Comment Code					
Inspector Comment					
DS_ID:19756 FS_ID:70983 EP_NO: N/A Repair Type: Non-Urgent EVAL Issue: 6, Levee Damage or Threat for Levee Damage Crossing Status: Found UCIP Comments: 06/1/2021 Record remains Non-Urgent. DWR DMP internal inspection has not found pipe integrity issues. LOF of crossing is less or equal to 4.0. Recommend next video inspection in 5 years. Some soil sloughing/erosion on the WS slope. No permit was found authorizing this encroachment. CVFPB will need to review crossing to determine owner. The UCIP inspection was completed with GEI staff, P. Espinoza. (H. Dunn – GEI) 04/09/2014 Debris blocking landward headwall--recommend clearing. (W. Wylie - DWR UCIP) FIELD_STRUCT_DESC: 24-inch corrugated metal gravity drainage pipe (CMP) through the levee, 8.6 feet below the crown. Concrete U-shaped headwall and flap gate on the waterside (WS) end. Concrete headwall on the landside (LS) end. [Additional Reference(s): DWR Levee Log, 2002, (HLM 0.07). USACE San Joaquin O&M Manual, Unit No. 601, Part No. 1, 1967, Amended in 1978, Revised 20 June 1985, (HLM 0.07)]. FS Date: 6/1/2021

WS view: Sloughing on the slope from toe, 1 of 2 photos.

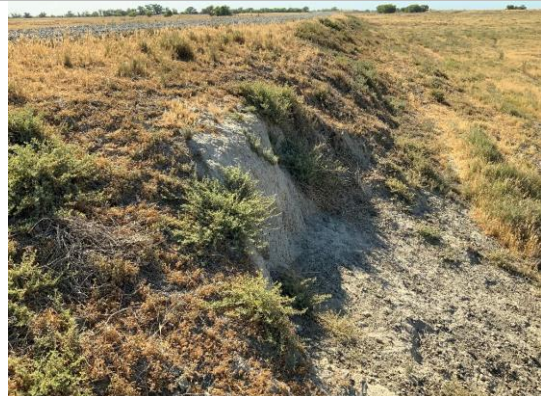
Photo 2 of 2 : UCIP_FA_2022_70983_99633.jpg

WS view: Side view of the sloughing on the slope, 2 of 2 photos.
