Flood Control Project Maintenance Levee Inspections

Fall 2022 Levee Maintenance Deficiency Summary Report

San Joaquin River Basin

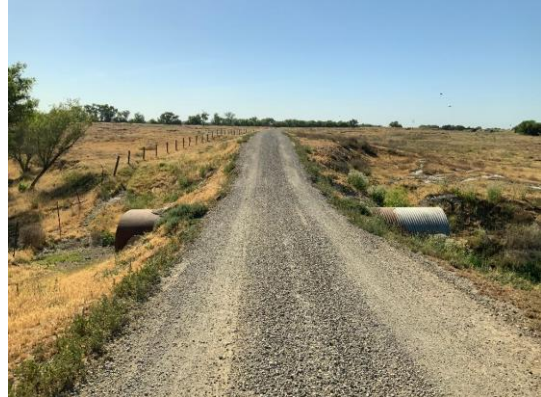
Photo 1 of 3 : UCIP_FA_2022_70984_99641.jpg

Comment Code					
Inspector Comment					
DS_ID:24867 FS_ID:70984 EP_NO: N/A Repair Type: Urgent EVAL Issue: 2b, Levee Integrity Crossing Status: Found UCIP Comments: 06/1/2021 Record remains Urgent. Same as previous inspection comments. There is no flapgate, the pipe is open on both ends. Pipe is being bent down from the top. Crown has subsided about 4 feet from the original crown. Minor erosion around pipe on both WS and LS. No permit was found authorizing this encroachment. CVFPB will need to review crossing to determine owner. The UCIP inspection was completed with GEI staff, P. Espinoza. (H. Dunn – GEI)					
11/01/2018 Same as previous inspection, 1960s levee breach; degraded levee section that drops about 4 feet within a 100-foot levee section. Crossing remains Urgent due to the levee degradation at this location. (O. Magana - DWR UCIP)07/20/2016 same as previous inspection. Levee section at crossing has been degraded. According to LMA representative, Rick, the low point at crossing has been present for over 10 years when the pipe was replaced. (O. Magana - DWR UCIP)04/09/2014 Pipe is open on both ends and levee has been degraded at this location. No permit identified for this crossing. (W. Wylie - DWR UCIP)

FIELD_STRUCT_DESC: 96-inch corrugated metal gravity drainage pipe (CMP) through the levee, 4.5 feet below the crown. Pipe is composed of two materials: CMP on the waterside (WS) and steel pipe on the landside (LS). This section of the levee is a degraded section that drops approximately 4 feet within 100 feet of length. This section of the levee is the site of the 1960s levee breach. [Additional Reference(s): USACE Periodic Inspection Report 2014, USACE_CESPK_L05A_2014_p_0014]. FS Date: 6/1/2021

Levee crown looking downstream. Crown is lower above pipe.

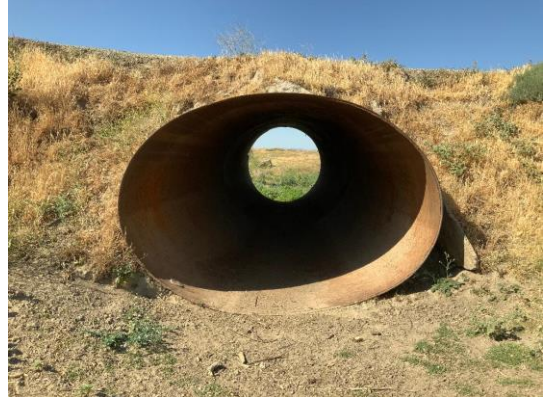
Photo 2 of 3 : UCIP_FA_2022_70984_99642.jpg

LS view: Slope and pipe inlet, top being bent down from toe.

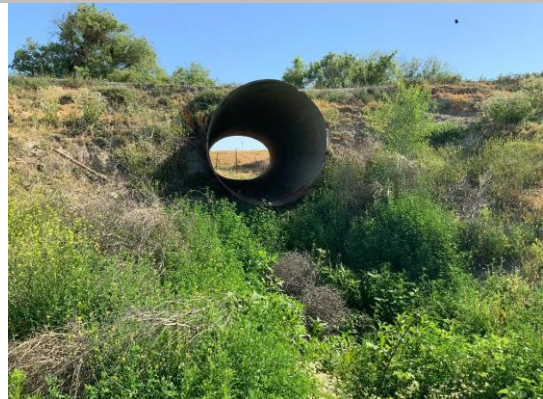
Photo 3 of 3 : UCIP_FA_2022_70984_99639.jpg

WS view: Slope and pipe outlet at toe.

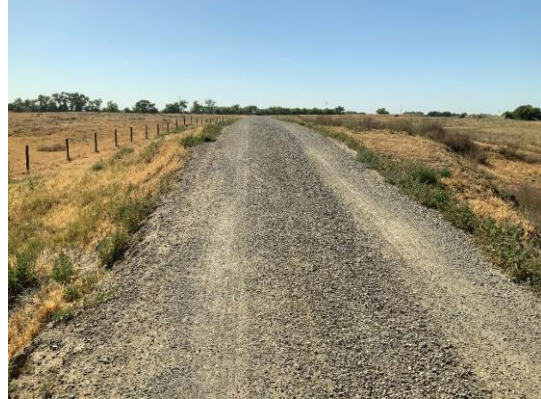
Photo 1 of 3 : UCIP_FA_2022_70985_99649.jpg

Comment Code						
Inspector Comment						
DS_ID:19557 FS_ID:70985 EP_NO: N/A Repair Type: Non-Urgent EVAL Issue: Crossing Status: Not Found UCIP Comments: 06/1/2021 Record remains Non-Urgent. Pipe not found by visual inspection. No permit was found authorizing this encroachment. CVFPB will need to review crossing to determine owner. The UCIP inspection was completed with GEI staff, P. Espinoza. (H. Dunn – GEI)11/01/2018 24-inch corrugated metal pipe (CMP) section found during pipe inspection of dsid 24867 (see photos); according to LMA representative levee section is the location of levee breach from 1960s; 24-inch pipe was undersized and was replaced after levee breach with a 96-inch CMP and steel pipe. (O. Magana - DWR UCIP) FIELD_STRUCT_DESC: 24-inch corrugated metal gravity drainage pipe (CMP) through the levee, 5.6 feet below the crown. Flap gate on the waterside (WS) end. Large pipe found at this location. [Additional Reference(s): USACE San Joaquin O&M Manual, Unit No. 601, Part No. 1, 1967, Amended in 1978, Revised 20 June 1985, (HLM 0.30)]. FS Date: 6/1/2021

Levee crown looking downstream.

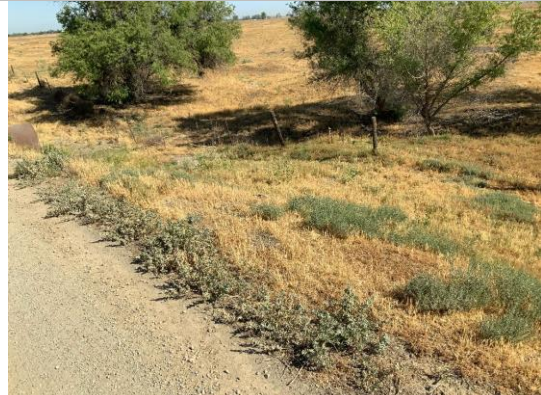
Photo 2 of 3 : UCIP_FA_2022_70985_99648.jpg

LS view: Slope and toe from crown, no pipe visible.

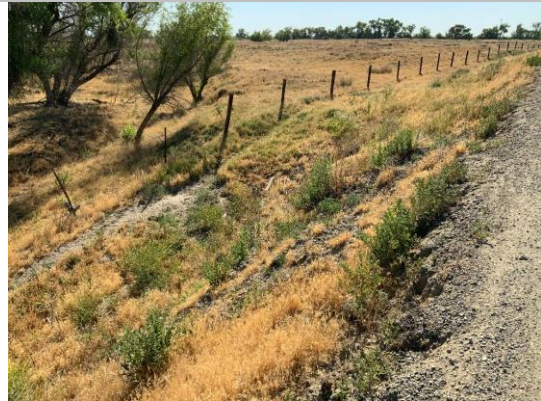
Photo 3 of 3 : UCIP_FA_2022_70985_99650.jpg

LS view: Toe from crown, no pipe visible.

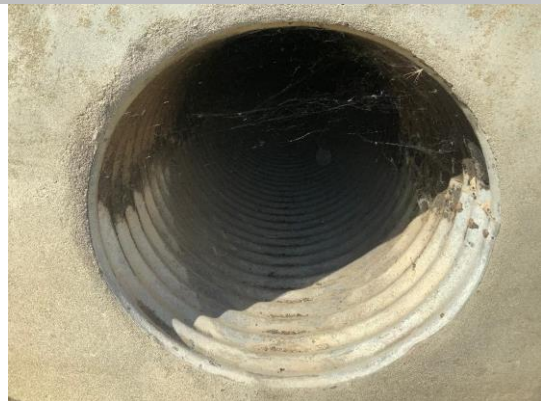
Photo 1 of 2 : UCIP_FA_2022_70986_99656.jpg

DS_ID:19757
 FS_ID:70986
 EP_NO: N/A
 Repair Type: Non-Urgent
 EVAL Issue: 5, Pipe Damage
 Crossing Status: Found
 UCIP Comments: 06/1/2021 Record remains Non-Urgent. DWR DMP internal inspection has found pipe integrity issues. LOF of crossing is greater than or equal to 4.1 and less than 5. Crossing will be monitored until funding becomes available for rehabilitation. No permit was found authorizing this encroachment. CVFPB will need to review crossing to determine owner. The UCIP inspection was completed with GEI staff, P. Espinoza. (H. Dunn – GEI) 04/09/2014 Excess debris on landward headwall--recommend clearing. (W. Wylie - DWR UCIP)
 FIELD_STRUCT_DESC: 30-inch corrugated metal gravity drainage pipe (CMP) through the levee, 7.5 feet below the crown. Flap gate on the waterside (WS) end. Concrete headwall on the landside (LS) end. Concrete U-shaped headwall on the WS end. [Additional Reference(s): DWR Levee Log, 2002, (HLM 0.58). USACE San Joaquin O&M Manual, Unit No. 601, Part No. 1, 1967, Amended in 1978, Revised 20 June 1985, (HLM 0.59). DWR As-Built Specification No. 63-25, Sheet No. 4, 9 May 1963, (Station -2+15)].

LS view: Close up of pipe inlet at toe.

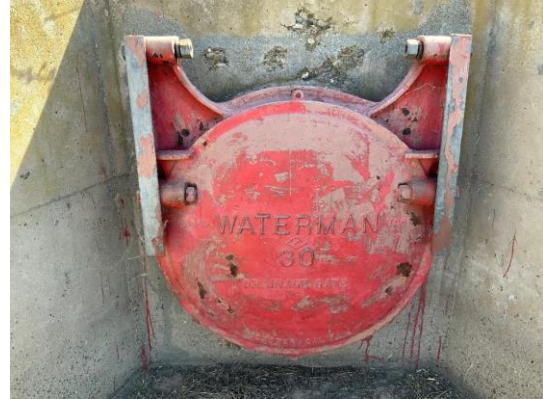
Photo 2 of 2 : UCIP_FA_2022_70986_99653.jpg

WS view: Close up of flapgate at toe.

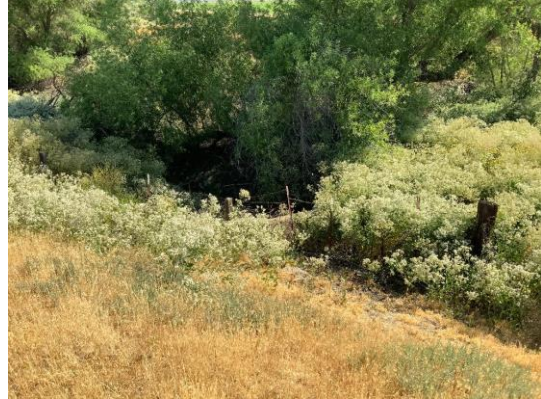
Photo 1 of 2 : UCIP_FA_2022_70987_99660.jpg

DS_ID:19758
FS_ID:70987
EP_NO: N/A
Repair Type: Urgent
EVAL Issue: 1, Pipe Integrity
Crossing Status: Found
UCIP Comments: 06/1/2021 Record has been upgraded from Non-Urgent to Urgent. DWR DMP internal inspection has found pipe integrity issues. LOF of crossing is greater than or equal to 5 and less than 6. Crossing will be monitored until funding becomes available to address the issues. No closeup inspection of LS pipe end due to dense vegetation and barbed wire. No permit was found authorizing this encroachment. CVFPB will need to review crossing to determine owner. The UCIP inspection was completed with GEI staff, P. Espinoza. (H. Dunn – GEI)04/09/2014 Dense vegetation limits the inspector's visibility to identify signs of pipe failure (leaks) along the landward slope. Recommend removing vegetation along pipe alignment to conduct proper inspection of structure. (W. Wylie - DWR UCIP)
FIELD_STRUCT_DESC: 36-inch corrugated metal gravity drainage pipe (CMP) through the levee, 13.2 feet below the crown. Flap gate on the waterside (WS) end. Concrete headwall on the landside (LS) end. Concrete U-shaped headwall on the WS end. Cobble revetment around both ends. [Additional Reference(s): DWR Levee Log, 2002, (HLM 0.64). USACE San Joaquin O&M Manual, Unit No. 601, Part No. 1, 1967, Amended in 1978, Revised 20 June 1985, (HLM 0.65). DWR As-Built Specification No. 63-25, Sheet No. 4, 9 May 1963, (HLM 0.65)].

LS view: Headwall barely visible at toe from crown.

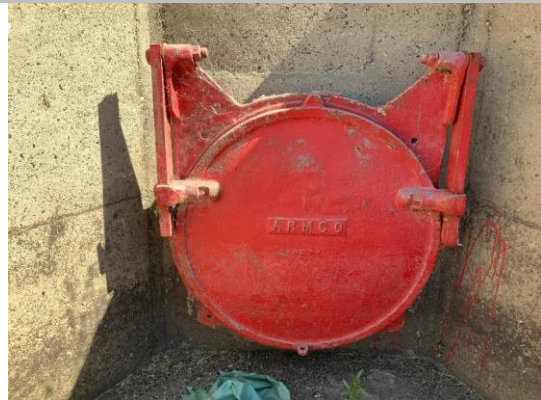
Photo 2 of 2 : UCIP_FA_2022_70987_99658.jpg

WS view: Close up of flapgate at toe.

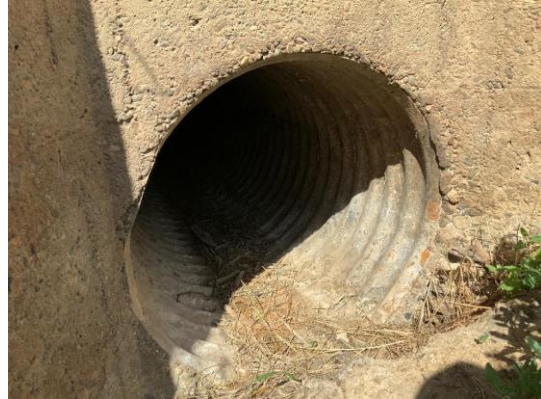
Photo 1 of 2 : UCIP_FA_2022_70988_99663.jpg

Comment Code						
Inspector Comment						
DS_ID:19759 FS_ID:70988 EP_NO: N/A Repair Type: Urgent EVAL Issue: 1, Pipe Integrity Crossing Status: Found UCIP Comments: 06/1/2021 Record has been upgraded from No Action Needed to Urgent. DWR DMP internal inspection has found pipe integrity issues. LOF of crossing is greater than or equal to 5 and less than 6. Crossing will be monitored until funding becomes available to address the issues. No permit was found authorizing this encroachment. CVFPB will need to review crossing to determine owner. The UCIP inspection was completed with GEI staff, P. Espinoza. (H. Dunn – GEI) FIELD_STRUCT_DESC: 24-inch corrugated metal gravity drainage pipe (CMP) through the levee, 14.4 feet below the crown. Flap gate on the waterside (WS) end. Concrete headwall on the landside (LS) end. Concrete U-shaped headwall on the WS end. [Additional Reference(s): DWR Levee Log, 2002, (HLM 0.84). USACE San Joaquin O&M Manual, Unit No. 601, Part No. 1, 1967, Amended in 1978, Revised 20 June 1985, (HLM 0.84). DWR As-Built Specification No. 63-25, Sheet No. 4, 9 May 1963, (HLM 0.84)]. FS Date: 6/1/2021

LS view: Close up of pipe inlet at toe.

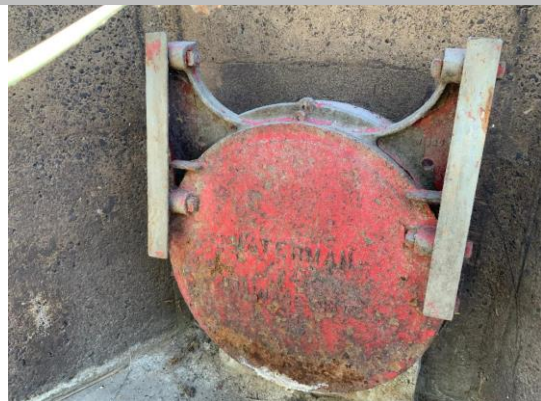
Photo 2 of 2 : UCIP_FA_2022_70988_99667.jpg

WS view: Close up of flapgate at toe.

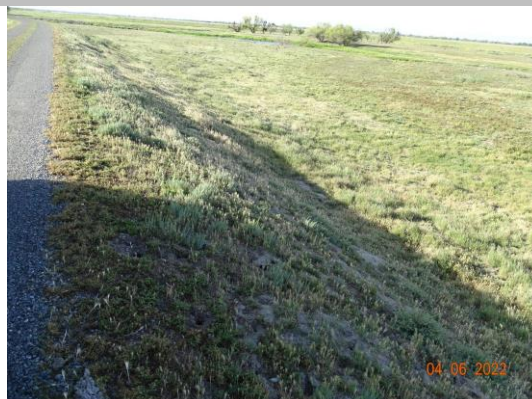
Photo 1 of 1 : FA_2022_NA0010_123_154_20220822_00045.jpg

LM Start	0.90	Rating **	A/W	Issue No.	154
LM End	0.90	Issue Type +	Ma	Location *	WS
Category	Earthen Levee			GPS Latitude/Longitude	
				Start	End
Item	Erosion / Livestock			37.271264 °	37.271264 °
				-120.811934 °	-120.811934 °
DWR ID	DWR_NA0010_05_s_2022_154				
Comment Code					
E4 : Repair the levee slope damaged by livestock and prevent large animal access.					
Inspector Comment					
Shallow depression on the lower 1/3 of the waterside slope. Possibly from livestock, but no visible trail leading to the depression. Continue to monitor.

View of minor slope erosion on the waterside. (Spring 2022)

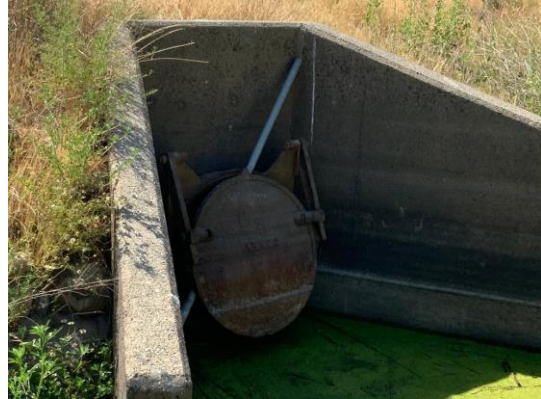
Photo 1 of 2 : UCIP_FA_2022_70989_99675.jpg

Comment Code					
Inspector Comment					
DS_ID:19760 FS_ID:70989 EP_NO: N/A Repair Type: Non-Urgent EVAL Issue: 11, Maintenance Compliance Issue Crossing Status: Found UCIP Comments: 06/1/2021 The record has been upgraded from No Action Needed to Non-Urgent. LS pipe inlet blocked by barbed wire, could not inspect. Small pipe lodged in the WS flapgate so it cannot be closed all the way, recommend removal before flood season. No permit was found authorizing this encroachment. CVFPB will need to review crossing to determine owner. The UCIP inspection was completed with GEI staff, P. Espinoza. (H. Dunn – GEI) FIELD_STRUCT_DESC: 36-inch corrugated metal gravity drainage pipe (CMP) through the levee, 21.0 feet below the crown. Flap gate on the waterside (WS) end. Concrete headwall on the landside (LS) end. Concrete U-shaped headwall on the WS end. [Additional Reference(s): DWR Levee Log, 2002, (HLM 1.44). USACE San Joaquin O&M Manual, Unit No. 601, Part No. 1, 1967, Amended in 1978, Revised 20 June 1985, (HLM 1.44). DWR As-Built Specification No. 63-25, Sheet No. 4, 9 May 1963, (HLM 1.44)]. FS Date: 6/1/2021

WS view: Close up of flapgate at toe, 1 of 2 photos.

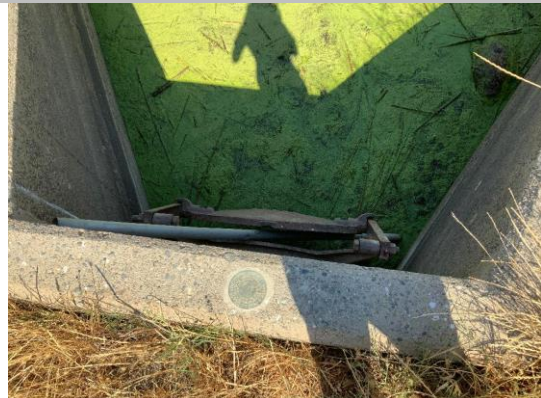
Photo 2 of 2 : UCIP_FA_2022_70989_99676.jpg

WS view: Close up of flapgate at toe with bar sticking through, 2 of 2 photos.

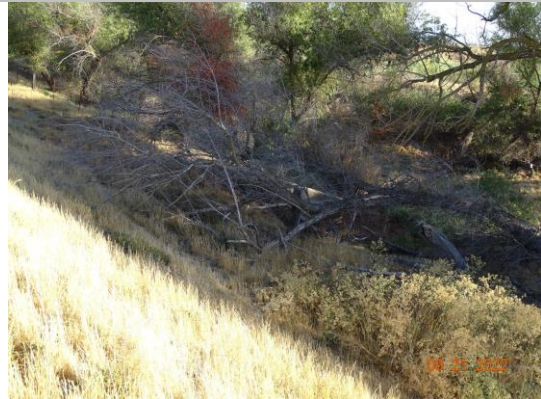
Photo 1 of 1 : FA_2022_NA0010_123_159_20221010_00362.jpg

LM Start	1.47	Rating **	M	Issue No.	159
LM End	1.47	Issue Type +	Ma	Location *	LS
Category	Earthen Levee			GPS Latitude/Longitude	
				Start	End
Item	Trim / Thin Trees			37.265605 °	37.265605 °
				-120.804784 °	-120.804784 °
DWR ID	DWR_NA0010_05_f_2022_159				
Comment Code					
T2 : Tree or limb.					
Inspector Comment					
Downed tree branch on the landside toe.

Fallen tree on the landside slope and toe. (Fall 2022)

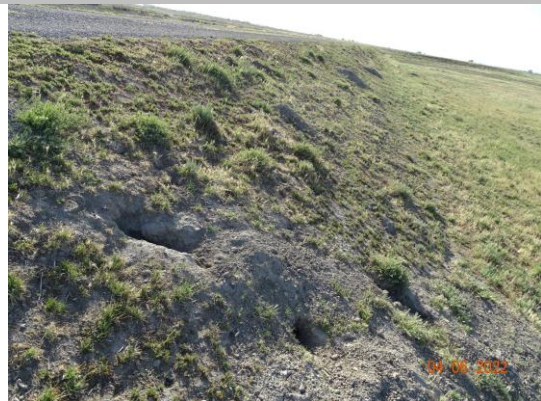
Photo 1 of 1 : FA_2022_NA0010_123_156_20220822_00047.jpg

LM Start	1.53	Rating **	U	Issue No.	156
LM End	1.53	Issue Type +	Ma	Location *	WS
Category	Earthen Levee			GPS Latitude/Longitude	
				Start	End
Item	Animal Control			37.265008 °	37.265008 °
				-120.804010 °	-120.804010 °
DWR ID	DWR_NA0010_05_s_2022_156				
Comment Code					
A3 : No rodents visible, but rodent burrows visible; need to backfill and compact or grout burrows.					
Inspector Comment					
Several rodent burrows observed. A few appear to penetrate the levee through to the landside.

Several rodent holes observed on the waterside slope. (Spring 2022)

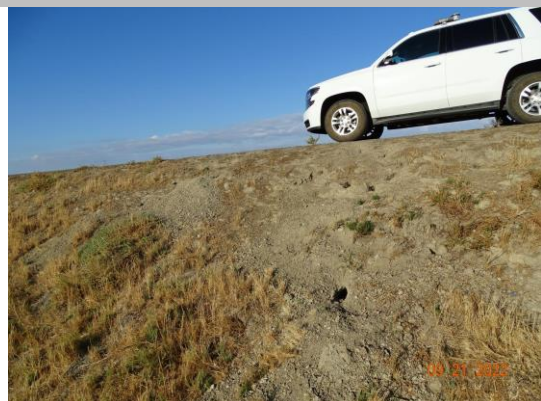
Photo 1 of 1 : FA_2022_NA0010_123_172_20221010_00363.jpg

LM Start	1.67	Rating **	M	Issue No.	172
LM End	1.67	Issue Type +	Ma	Location *	LS
Category	Earthen Levee			GPS Latitude/Longitude	
				Start	End
Item	Animal Control			37.263363 °	37.263363 °
				-120.802729 °	-120.802729 °
DWR ID	DWR_NA0010_05_f_2022_172				
Comment Code					
A3 : No rodents visible, but rodent burrows visible; need to backfill and compact or grout burrows.					
Inspector Comment

Rodent burrows on the landside slope. (Fall 2022)

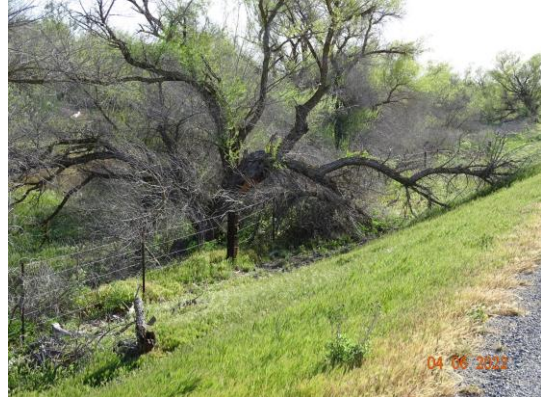
Photo 1 of 1 : FA_2022_NA0010_123_102_20220822_00011.jpg

LM Start	2.82	Rating **	M	Issue No.	102
LM End	2.82	Issue Type +	Ma	Location *	LS
Category	Earthen Levee			GPS Latitude/Longitude	
				Start	End
Item	Trim / Thin Trees			37.256805 °	37.256805 °
				-120.785434 °	-120.785434 °
DWR ID	DWR_NA0010_05_s_2019_102				
Comment Code					
T2 : Tree or limb.					
Inspector Comment

Tree limb has fallen on the landside slope and toe. (Spring 2022)

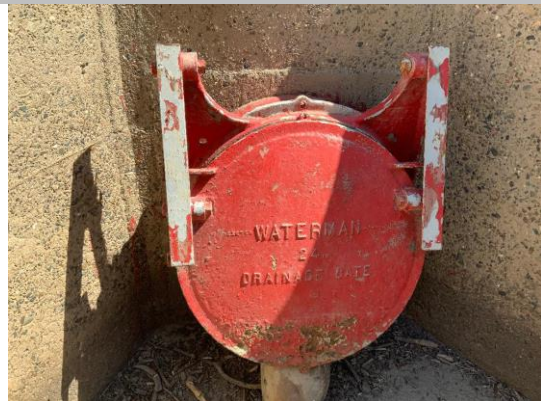
Photo 1 of 1 : UCIP_FA_2022_70990_99683.jpg

Comment Code					
Inspector Comment					
DS_ID:19809 FS_ID:70990 EP_NO: N/A Repair Type: Non-Urgent EVAL Issue: 5, Pipe Damage Crossing Status: Found UCIP Comments: 06/1/2021 Record remains Non-Urgent. DWR DMP internal inspection has found pipe integrity issues. LOF of crossing is between 4.1 and 5. Crossing will be monitored until funding becomes available for rehabilitation. Barbed wire over LS end, could not inspect. No permit was found authorizing this encroachment. CVFPB will need to review crossing to determine owner. The UCIP inspection was completed with GEI staff, P. Espinoza. (H. Dunn – GEI) 04/09/2014 Log partially blocking inlet at LS toe. (W. Wylie - DWR UCIP) FIELD_STRUCT_DESC: 24-inch corrugated metal gravity drainage pipe (CMP) through the levee, 15.0 feet below the crown. Flap gate on the waterside (WS) end. Concrete U-shaped headwall on each end. [Additional Reference(s): DWR Levee Log, 2002, (HLM 2.83). USACE San Joaquin O&M Manual, Unit No. 601, Part No. 1, 1967, Amended in 1978, Revised 20 June 1985, (HLM 2.85). DWR As-Built Specification No. 63-25, Sheet No. 5, 9 May 1963, (HLM 2.85)]. FS Date: 6/1/2021

WS view: Close up of flapgate at toe.

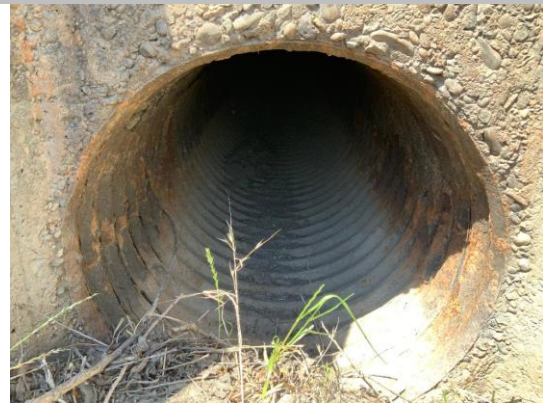
Photo 1 of 3 : UCIP_FA_2022_70991_99684.jpg

Comment Code						
Inspector Comment						
DS_ID:19810 FS_ID:70991 EP_NO: N/A Repair Type: Non-Urgent EVAL Issue: 5, Pipe Damage Crossing Status: Found UCIP Comments: 06/1/2021 Record remains Non-Urgent. DWR DMP internal inspection has found pipe integrity issues. LOF of crossing is between 4.1 and 5. Crossing will be monitored until funding becomes available for rehabilitation. Pipe is eroded through causing holes just behind the WS flapgate. Metal peeling away inside of pipe outlet. Flapgate is rusted with some corrosion. No permit was found authorizing this encroachment. CVFPB will need to review crossing to determine owner. The UCIP inspection was completed with GEI staff, P. Espinoza. (H. Dunn – GEI) 04/15/2014 Pipe corroded through at flapgate on WS toe. (W. Wylie - DWR UCIP) FIELD_STRUCT_DESC: 24-inch corrugated metal gravity drainage pipe (CMP) through the levee, 14.7 feet below the crown. Flap gate on the waterside (WS) end. Concrete U-shaped headwall on each end. [Additional Reference(s): DWR Levee Log, 2002, (HLM 3.36). USACE San Joaquin O&M Manual, Unit No. 601, Part No. 1, 1967, Amended in 1978, Revised 20 June 1985, (HLM 3.33). DWR As-Built Specification No. 63-25, Sheet No. 5, 9 May 1963, (HLM 3.33)]. FS Date: 6/1/2021

LS view: Close up of pipe inlet at toe.

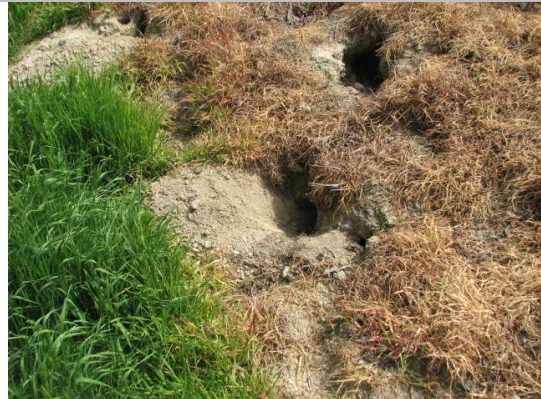
Photo 1 of 1 : FA_2022_NA0010_123_134_20220822_00032.jpg

LM Start	3.55	Rating **	M	Issue No.	134
LM End	3.55	Issue Type +	Ma	Location *	LS
Category	Earthen Levee			GPS Latitude/Longitude	
				Start	End
Item	Animal Control			37.255202 °	37.255202 °
				-120.773655 °	-120.773655 °
DWR ID	DWR_NA0010_05_f_2018_134				
Comment Code					
A3 : No rodents visible, but rodent burrows visible; need to backfill and compact or grout burrows.					
Inspector Comment

Looking at typical rodent holes within this section. (Spring 2018)

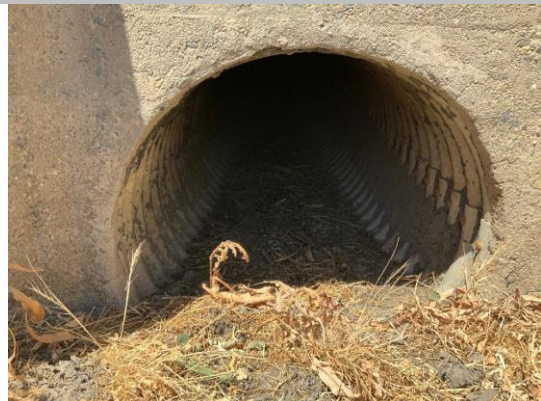
Photo 1 of 1 : UCIP_FA_2022_70992_99695.jpg

Comment Code					
Inspector Comment					
DS_ID:19811 FS_ID:70992 EP_NO: N/A Repair Type: Non-Urgent EVAL Issue: 11, Maintenance Compliance Issue Crossing Status: Found UCIP Comments: 06/1/2021 Record remains Non-Urgent. Some debris buildup within the LS pipe inlet, recommend cleaning out. No permit was found authorizing this encroachment. CVFPB will need to review crossing to determine owner. The UCIP inspection was completed with GEI staff, P. Espinoza. (H. Dunn – GEI) 04/16/2014 Sediment buildup in pipe visible from landward side--recommend contacting owner to clear pipe. (W. Wylie - DWR UCIP) FIELD_STRUCT_DESC: 24-inch corrugated metal gravity drainage pipe (CMP) through the levee, 15.0 feet below the crown. Flap gate on the waterside (WS) end. Concrete headwall on the landside (LS) end. Concrete U-shaped headwall on the WS end. [Additional Reference(s): DWR Levee Log, 2002, (HLM 3.67). USACE San Joaquin O&M Manual, Unit No. 601, Part No. 1, 1967, Amended in 1978, Revised 20 June 1985, (HLM 3.67). DWR As-Built Specification No. 63-25, Sheet No. 6, 9 May 1963, (HLM 3.67)]. FS Date: 6/1/2021

LS view: Close up of pipe inlet at toe, some debris buildup.

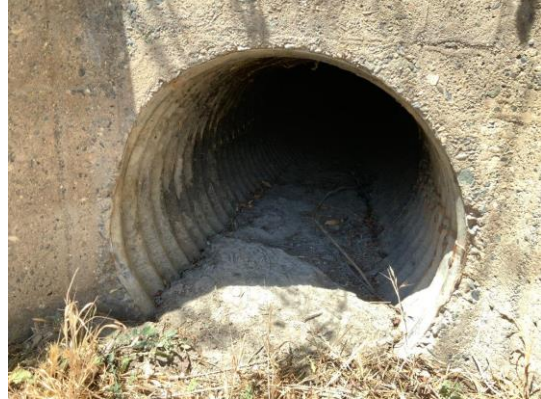
Photo 1 of 1 : UCIP_FA_2022_70993_99703.jpg

Comment Code					
Inspector Comment					
DS_ID:19769 FS_ID:70993 EP_NO: N/A Repair Type: Non-Urgent EVAL Issue: 11, Maintenance Compliance Issue Crossing Status: Found UCIP Comments: 06/1/2021 Record remains Non-Urgent. Some sediment buildup in LS pipe inlet, recommend cleaning out. No permit was found authorizing this encroachment. CVFPB will need to review crossing to determine owner. The UCIP inspection was completed with GEI staff, P. Espinoza. (H. Dunn – GEI) 04/16/2014 Sediment buildup in pipe visible from landward side--recommend contacting owner to clear pipe. (W. Wylie - DWR UCIP) FIELD_STRUCT_DESC: 24-inch corrugated metal gravity drainage pipe (CMP) through the levee, 16.0 feet below the crown. Flap gate on the waterside (WS) end. Concrete U-shaped headwall on each end. [Additional Reference(s): DWR Levee Log, 2002, (HLM 4.01). USACE San Joaquin O&M Manual, Unit No. 601, Part No. 1, 1967, Amended in 1978, Revised 20 June 1985, (HLM 4.02). DWR As-Built Specification No. 63-25, Sheet No. 6, 9 May 1963, (HLM 4.02)]. FS Date: 6/1/2021

LS view: Close up of pipe inlet with sediment buildup at toe.

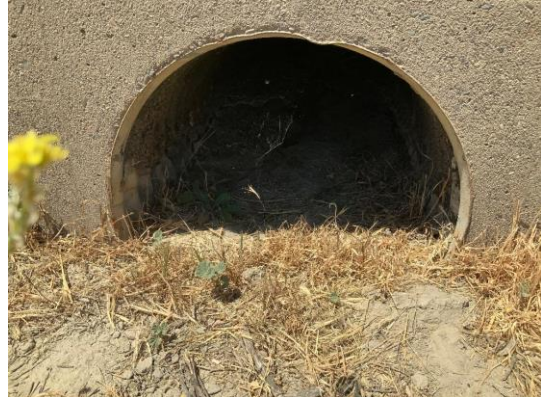
Photo 1 of 3 : UCIP_FA_2022_70994_99715.jpg

DS_ID:19770
FS_ID:70994
EP_NO: N/A
Repair Type: Non-Urgent
EVAL Issue: 11, Maintenance Compliance Issue
Crossing Status: Found
UCIP Comments: 06/1/2021 Record remains Non-Urgent. Sizable burrow complex on WS slope, with several holes around 3-4 inches wide, recommend filling in for levee integrity. There is also sediment buildup within the LS pipe inlet, recommend cleaning out. No permit was found authorizing this encroachment. CVFPB will need to review crossing to determine owner. The UCIP inspection was completed with GEI staff, P. Espinoza. (H. Dunn – GEI) 04/16/2014 Sediment buildup in pipe visible from landward side--recommend contacting owner to clear pipe. (W. Wylie - DWR UCIP)
FIELD_STRUCT_DESC: 24-inch corrugated metal gravity drainage pipe (CMP) through the levee, 11.6 feet below the crown. Flap gate on the waterside (WS) end. Concrete headwall on the landside (LS) end. Concrete U-shaped headwall on the WS end. [Additional Reference(s): DWR Levee Log, 2002, (HLM 4.27). USACE San Joaquin O&M Manual, Unit No. 601, Part No. 1, 1967, Amended in 1978, Revised 20 June 1985, (HLM 4.27). DWR As-Built Specification No. 63-25, Sheet No. 6, 9 May 1963, (HLM 4.27)].

LS view: Close up of pipe inlet with sediment buildup at toe.

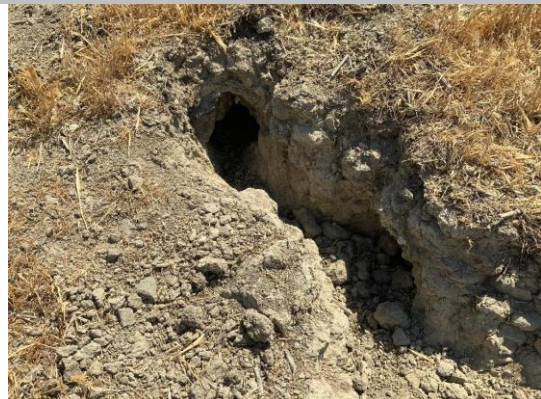
Photo 2 of 3 : UCIP_FA_2022_70994_99713.jpg

WS view: Burrow complex holes, 1 of 3 photos.

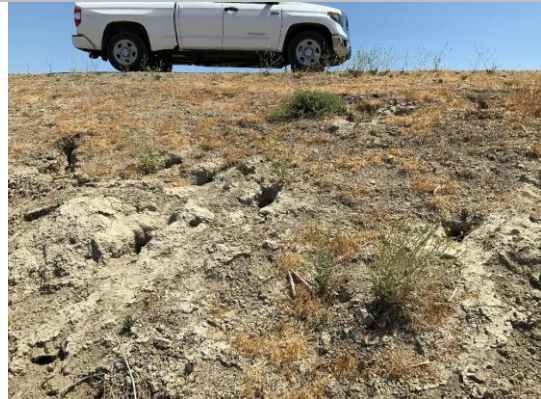
Photo 3 of 3 : UCIP_FA_2022_70994_99709.jpg

WS view: Burrow complex holes on slope from toe, 3 of 3 photos.

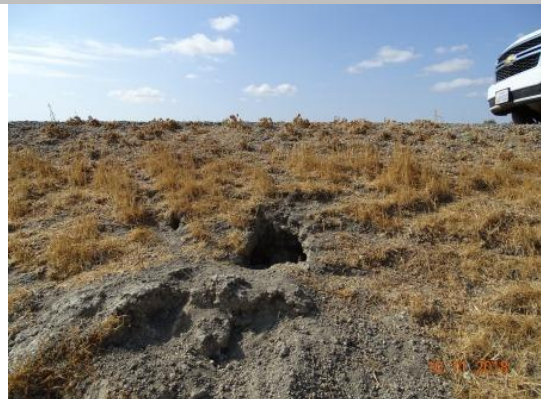
Photo 1 of 1 : FA_2022_NA0010_123_131_20220822_00031.jpg

LM Start	4.33	Rating **	U	Issue No.	131
LM End	4.33	Issue Type +	Ma	Location *	LS
Category	Earthen Levee			GPS Latitude/Longitude	
				Start	End
Item	Animal Control			37.245406 °	37.245406 °
				-120.759971 °	-120.759971 °
DWR ID	DWR_NA0010_05_f _ 2018_131				
Comment Code					
A3 : No rodents visible, but rodent burrows visible; need to backfill and compact or grout burrows.					
Inspector Comment					
Several large rodent holes are located on both sides of levee.

View of a large rodent hole in landward slope. (Fall 2018)

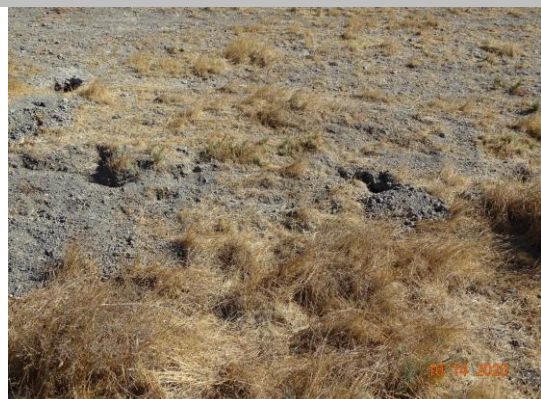
Photo 1 of 1 : FA_2022_NA0010_123_117_20220822_00019.jpg

LM Start	4.33	Rating **	M	Issue No.	117
LM End	4.33	Issue Type +	Ma	Location *	WS
Category	Earthen Levee			GPS Latitude/Longitude	
				Start	End
Item	Animal Control			37.245421 °	37.245421 °
				-120.759943 °	-120.759943 °
DWR ID	DWR_NA0010_05_f_2017_117				
Comment Code					
A1 : Exterminate rodents and backfill and compact or grout burrows.					
Inspector Comment

Several rodent burrows observed at this location. (Fall 2020)

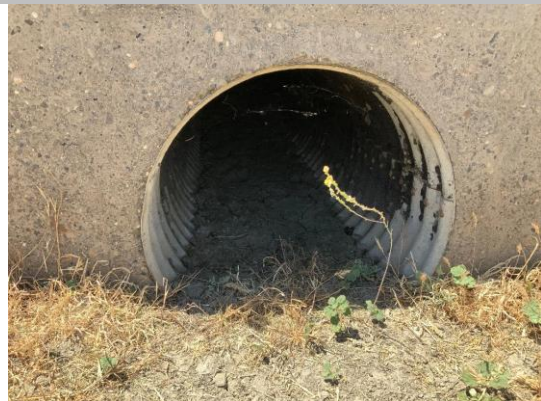
Photo 1 of 1 : UCIP_FA_2022_70995_99718.jpg

Comment Code					
Inspector Comment					
DS_ID:19771 FS_ID:70995 EP_NO: N/A Repair Type: Non-Urgent EVAL Issue: 11, Maintenance Compliance Issue Crossing Status: Found UCIP Comments: 06/1/2021 Record remains Non-Urgent. LS pipe inlet has sediment buildup inside, recommend cleaning out. No permit was found authorizing this encroachment. CVFPB will need to review crossing to determine owner. The UCIP inspection was completed with GEI staff, P. Espinoza. (H. Dunn – GEI) 04/16/2014 Sediment buildup in pipe visible from landward side--recommend contacting owner to clear pipe. (W. Wylie - DWR UCIP) FIELD_STRUCT_DESC: 24-inch corrugated metal gravity drainage pipe (CMP) through the levee, 12.0 feet below the crown. Flap gate on the waterside (WS) end. Concrete headwall on the landside (LS) end. Concrete U-shaped headwall on the WS end. [Additional Reference(s): DWR Levee Log, 2002, (HLM 4.53). USACE San Joaquin O&M Manual, Unit No. 601, Part No. 1, 1967, Amended in 1978, Revised 20 June 1985, (HLM 4.54). DWR As-Built Specification No. 63-25, Sheet No. 6, 9 May 1963, (HLM 4.54)]. FS Date: 6/1/2021

LS view: Close up of pipe inlet with sediment buildup at toe.

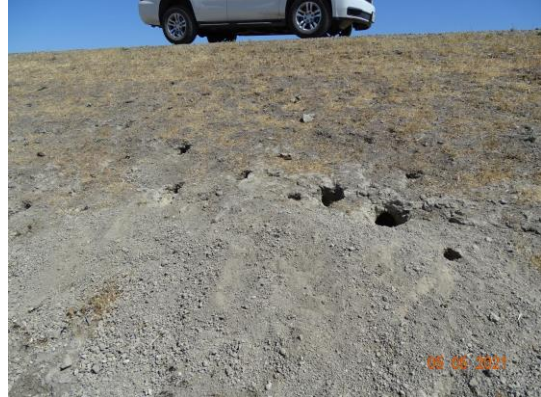
Photo 1 of 1 : FA_2022_NA0010_123_100_20220822_00009.jpg

LM Start	4.85	Rating **	M	Issue No.	100
LM End	4.85	Issue Type +	Ma	Location *	WS
Category	Earthen Levee			GPS Latitude/Longitude	
				Start	End
Item	Animal Control			37.241127 °	37.241127 °
				-120.752398 °	-120.752398 °
DWR ID	DWR_NA0010_05_s_2021_100				
Comment Code					
A1 : Exterminate rodents and backfill and compact or grout burrows.					
Inspector Comment					
Several burrows and rodents observed at this location. Bait stations have been set up.

Several rodent burrows noted at this location. (Spring 2021)

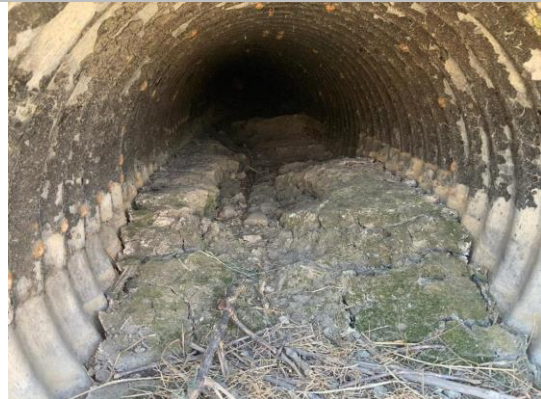
Photo 1 of 1 : UCIP_FA_2022_70996_100748.jpg

Comment Code					
Inspector Comment					
DS_ID:19772 FS_ID:70996 EP_NO: N/A Repair Type: Non-Urgent EVAL Issue: 11, Maintenance Compliance Issue Crossing Status: Found UCIP Comments: 06/1/2021 The record remains Non-Urgent. LS pipe inlet has sediment buildup, recommend cleaning out. No permit was found authorizing this encroachment. CVFPB will need to review crossing to determine owner. The UCIP inspection was completed with GEI staff, P. Espinoza. (H. Dunn – GEI) 04/16/2014 Heavy sediment buildup in pipe visible from landward side--recommend contacting owner to clear pipe. (W. Wylie - DWR UCIP) FIELD_STRUCT_DESC: 24-inch corrugated metal gravity drainage pipe (CMP) through the levee, 12.3 feet below the crown. Flap gate on the waterside (WS) end. Concrete headwall on the landside (LS) end. Concrete U-shaped headwall on the WS end. [Additional Reference(s): DWR Levee Log, 2002, (HLM 4.89). USACE San Joaquin O&M Manual, Unit No. 601, Part No. 1, 1967, Amended in 1978, Revised 20 June 1985, (HLM 4.89). DWR As-Built Specification No. 63-25, Sheet No. 7, 9 May 1963, (HLM 4.89)]. FS Date: 6/1/2021

LS view: Inside pipe inlet with sediment buildup at toe.

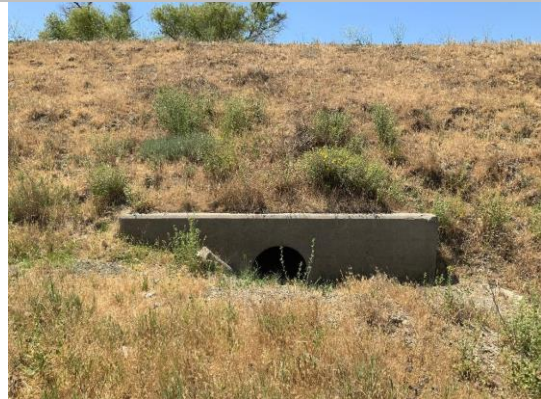
Photo 3 of 3 : UCIP_FA_2022_70997_100754.jpg

Comment Code					
Inspector Comment					
DS_ID:19773 FS_ID:70997 EP_NO: N/A Repair Type: Non-Urgent EVAL Issue: Crossing Status: Found UCIP Comments: 06/1/2021 The record remains Non-Urgent. Crossing appears to be in good condition. No permit was found authorizing this encroachment. CVFPB will need to review crossing to determine owner. The UCIP inspection was completed with GEI staff, P. Espinoza. (H. Dunn – GEI) 04/16/2014 Heavy sediment buildup in pipe visible from landward side--recommend contacting owner to clear pipe. (W. Wylie - DWR UCIP) FIELD_STRUCT_DESC: 24-inch corrugated metal gravity drainage pipe (CMP) through the levee, 12.2 feet below the crown. Flap gate on the waterside (WS) end. Concrete headwall on the landside (LS) end. Concrete U-shaped headwall on the WS end. [Additional Reference(s): DWR Levee Log, 2002, (HLM 5.14). USACE San Joaquin O&M Manual, Unit No. 601, Part No. 1, 1967, Amended in 1978, Revised 20 June 1985, (HLM 5.15). DWR As-Built Specification No. 63-25, Sheet No. 7, 9 May 1963, (HLM 5.15)]. FS Date: 6/1/2021

LS view: Slope and headwall at toe.

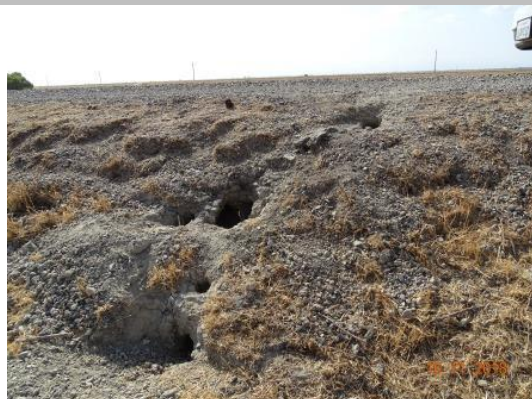
Photo 1 of 1 : FA_2022_NA0010_123_138_20220822_00034.jpg

LM Start	5.94	Rating **	U	Issue No.	138
LM End	5.94	Issue Type +	Ma	Location *	LS
Category	Earthen Levee			GPS Latitude/Longitude	
				Start	End
Item	Animal Control			37.236387 °	37.236387 °
				-120.734164 °	-120.734164 °
DWR ID	DWR_NA0010_05_f_2018_138				
Comment Code					
A1 : Exterminate rodents and backfill and compact or grout burrows.					
Inspector Comment					
Several large rodent holes are located at this location.

View of large rodent holes in landside slope. (Fall 2018)

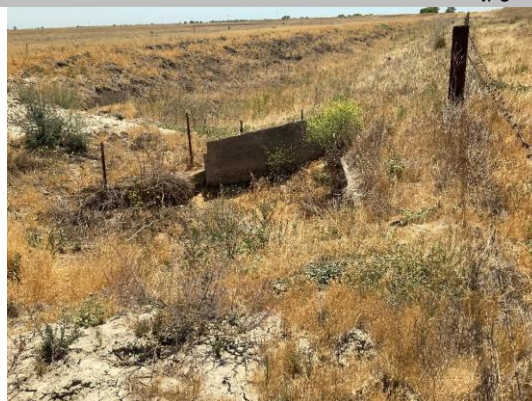
Photo 3 of 3 : UCIP_FA_2022_70999_100771.jpg

Comment Code					
Inspector Comment					
DS_ID:19775 FS_ID:70999 EP_NO: N/A Repair Type: Non-Urgent EVAL Issue: Crossing Status: Found UCIP Comments: 06/1/2021 The record has been upgraded from No Action Needed to Non-Urgent. LS inlet blocked by barbed wire and was inaccessible, could not inspect. No permit was found authorizing this encroachment. CVFPB will need to review crossing to determine owner. The UCIP inspection was completed with GEI staff, P. Espinoza. (H. Dunn – GEI) FIELD_STRUCT_DESC: 24-inch corrugated metal gravity drainage pipe (CMP) through the levee, 13.0 feet below the crown. Flap gate on the waterside (WS) end. Concrete headwall on the landside (LS) end. Concrete U-shaped headwall on the WS end. [Additional Reference(s): DWR Levee Log, 2002, (HLM 6.35). USACE San Joaquin O&M Manual, Unit No. 601, Part No. 1, 1967, Amended in 1978, Revised 20 June 1985, (HLM 6.35). DWR As-Built Specification No. 63-25, Sheet No. 8, 9 May 1963, (HLM 6.35)]. FS Date: 6/1/2021

LS view: Headwall visible at toe behind barbed wire.

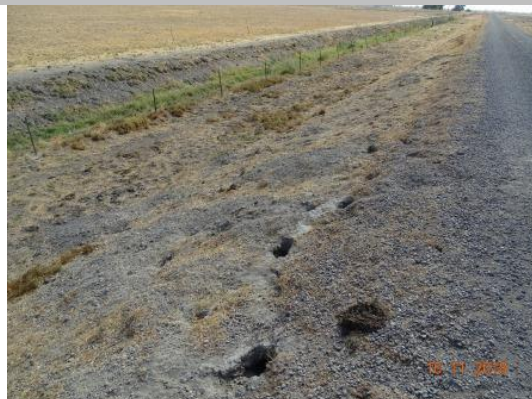
Photo 1 of 1 : FA_2022_NA0010_123_139_20220822_00035.jpg

LM Start	6.40	Rating **	M	Issue No.	139
LM End	6.40	Issue Type +	Ma	Location *	LS
Category	Earthen Levee			GPS Latitude/Longitude	
				Start	End
Item	Animal Control			37.231900 °	37.231900 °
				-120.728345 °	-120.728345 °
DWR ID	DWR_NA0010_05_f_2018_139				
Comment Code					
A1 : Exterminate rodents and backfill and compact or grout burrows.					
Inspector Comment

View of rodent holes on landside shoulder. (Fall 2018)

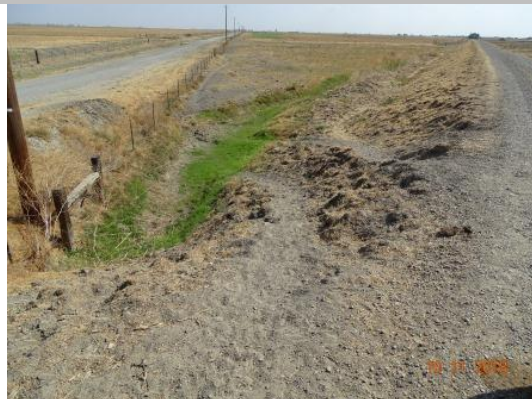
Photo 1 of 1 : FA_2022_NA0010_123_1309_20220822_00066.jpg

LM Start	6.59	Rating **	A/W	Issue No.	1309
LM End	6.59	Issue Type +	Ma	Location *	LS
Category	Earthen Levee			GPS Latitude/Longitude	
				Start	End
Item	Erosion / Livestock			37.229682 °	37.229682 °
				-120.726305 °	-120.726305 °
DWR ID	DWR_NA0010_05_s_2015_1309				
Comment Code					
E4 : Repair the levee slope damaged by livestock and prevent large animal access.					
Inspector Comment					
The landside slope has damage caused by animal foot traffic but the integrity of the levee is not compromised. Continue to monitor.

Looking upstream at damaged landside slope. (Fall 2018)

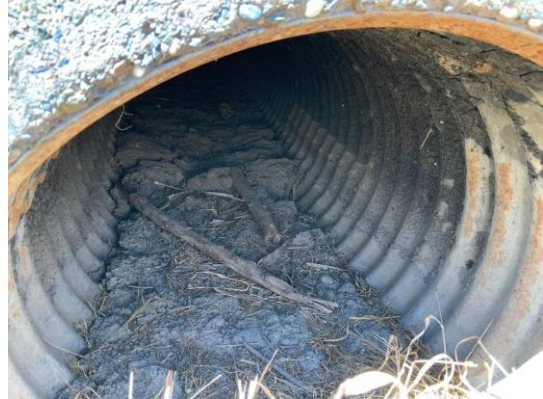
Photo 1 of 1 : UCIP_FA_2022_71000_100779.jpg

Comment Code						
Inspector Comment						
DS_ID:19761 FS_ID:71000 EP_NO: N/A Repair Type: Non-Urgent EVAL Issue: 11, Maintenance Compliance Issue Crossing Status: Found UCIP Comments: 06/9/2021 The record remains Non-Urgent. Sediment buildup in LS pipe inlet, recommend removal. No permit was found authorizing this encroachment. CVFPB will need to review crossing to determine owner. The UCIP inspection was completed with GEI staff, P. Espinoza. (H. Dunn – GEI) 04/22/2014 Sediment buildup in pipe visible from landward side--recommend contacting owner to clear pipe. (W. Wylie - DWR UCIP) FIELD_STRUCT_DESC: 24-inch corrugated metal gravity drainage pipe (CMP) through the levee, 12.0 feet below the crown. Flap gate on the waterside (WS) end. Concrete headwall on the landside (LS) end. Concrete U-shaped headwall on the WS end. [Additional Reference(s): DWR Levee Log, 2002, (HLM 7.36). USACE San Joaquin O&M Manual, Unit No. 601, Part No. 1, 1967, Amended in 1978, Revised 20 June 1985, (HLM 7.36). DWR As-Built Specification No. 63-25, Sheet No. 8, 9 May 1963, (HLM 7.36)]. FS Date: 6/9/2021

LS view: Closeup of pipe inlet with sediment buildup at toe.

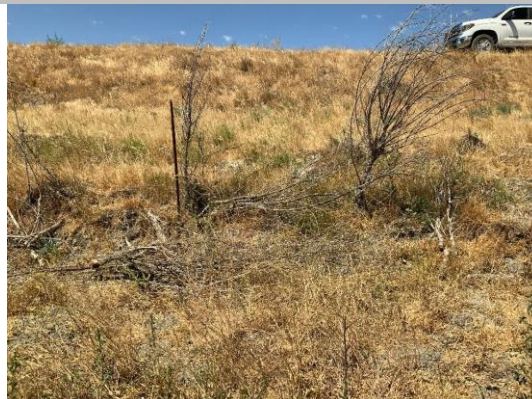
Photo 3 of 3 : UCIP_FA_2022_71001_100785.jpg

Comment Code						
Inspector Comment						
DS_ID:19762 FS_ID:71001 EP_NO: N/A Repair Type: Non-Urgent EVAL Issue: Crossing Status: Indicator Found UCIP Comments: 06/9/2021 The record remains Non-Urgent. No pipe visible on WS or LS during inspection, only indicator found. WS metal riser is bent. DWR DMP Geophysical study indicates possible presence of pipe through levee at (2305907, -13523234), coordinates have been updated. Owner needs to coordinate with the CVFPB to remove or abandon crossing according to Title 23 requirements. No permit was found authorizing this encroachment. CVFPB will need to review crossing to determine owner. The UCIP inspection was completed with GEI staff, P. Espinoza. (H. Dunn – GEI) 04/22/2014 Appears abandoned and if so should be done so properly. Slide gate rusted shut on WS slope. Unable to locate inlet or outlet. (W. Wylie - DWR UCIP) FIELD_STRUCT_DESC: 24-inch corrugated metal gravity drainage pipe (CMP) through the levee, 20.4 feet below the crown. Slide gate in a 36-inch CMP riser unit on the waterside (WS) slope. Concrete U-shaped headwall on each end. [Additional Reference(s): DWR Levee Log, 2002, (HLM 7.57). USACE San Joaquin O&M Manual, Unit No. 601, Part No. 1, 1967, Amended in 1978, Revised 20 June 1985, (HLM 7.58). DWR As-Built Specification No. 63-25, Sheet No. 9, 9 May 1963, (HLM 7.58)]. FS Date: 6/9/2021

LS view: Slope from toe, no pipe visible.

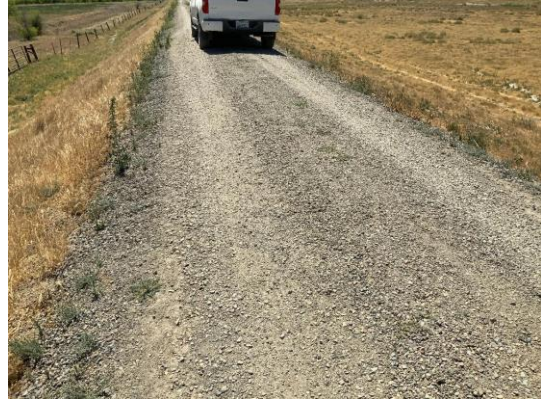
Photo 1 of 3 : UCIP_FA_2022_71003_100811.jpg

DS_ID:19763
FS_ID:71003
EP_NO: N/A
Repair Type: Non-Urgent
EVAL Issue:
Crossing Status: Found
UCIP Comments: 06/9/2021 The record remains Non-Urgent. Barbed wire over LS pipe inlet, limited inspection due to inaccessibility. No permit was found authorizing this encroachment. CVFPB will need to review crossing to determine owner. The UCIP inspection was completed with GEI staff, P. Espinoza. (H. Dunn – GEI) 04/22/2014 Pipe filled with silt on LS toe and should be cleared. (W. Wylie - DWR UCIP)
FIELD_STRUCT_DESC: 24-inch corrugated metal gravity drainage pipe (CMP) through the levee, 16.0 feet below the crown. Flap gate on the waterside (WS) end. Concrete headwall on the landside (LS) end. Concrete U-shaped headwall on the WS end. [Additional Reference(s): DWR Levee Log, 2002, (HLM 8.45). USACE San Joaquin O&M Manual, Unit No. 601, Part No. 1, 1967, Amended in 1978, Revised 20 June 1985, (HLM 8.44). DWR As-Built Specification No. 63-25, Sheet No. 9, 9 May 1963, (HLM 8.44)].

Levee crown looking upstream.

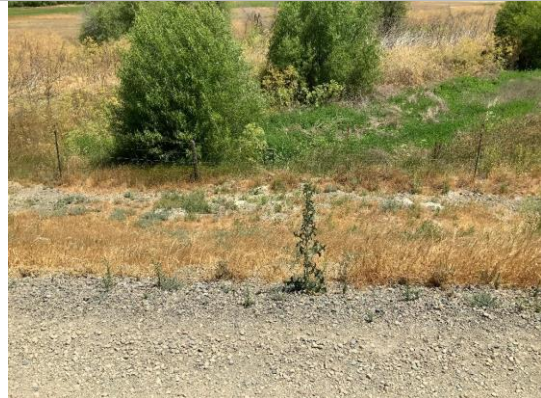
Photo 2 of 3 : UCIP_FA_2022_71003_100815.jpg

LS view: Toe from crown.

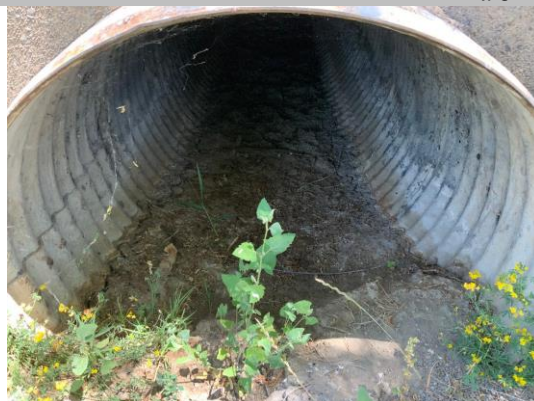
Photo 2 of 2 : UCIP_FA_2022_71009_100874.jpg

DS_ID:19766
 FS_ID:71009
 EP_NO: N/A
 Repair Type: Non-Urgent
 EVAL Issue: 4b, Safety Issue
 Crossing Status: Found
 UCIP Comments: 06/9/2021 The record has been upgraded from No Action Needed to Non-Urgent. LS pipe inlet was underwater during inspection, limited inspection. WS riser is missing half of the cover causing safety hazard. The LS pipe inlet is filled with sediment, recommend removal. No permit was found authorizing this encroachment. CVFPB will need to review crossing to determine owner. The UCIP inspection was completed with GEI staff, P. Espinoza. (H. Dunn – GEI)
 FIELD_STRUCT_DESC: 36-inch corrugated metal gravity drainage pipe (CMP) through the levee, 14.8 feet below the crown. Slide gate in a 48-inch CMP riser unit on the waterside (WS) slope. Concrete headwall on each end. [Additional Reference(s): DWR Levee Log, 2002, (HLM 9.24). USACE San Joaquin O&M Manual, Unit No. 601, Part No. 1, 1967, Amended in 1978, Revised 20 June 1985, (HLM 9.26). DWR As-Built Specification No. 61-01, Sheet No. 52, 7 March 1961, (HLM 9.26)].

WS view: Close up of pipe inlet at toe, filled with sediment.

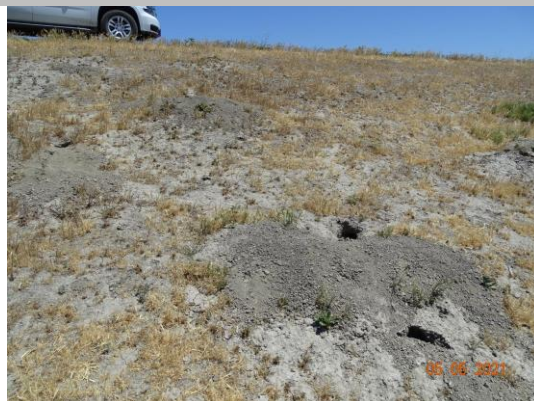
Photo 1 of 1 : FA_2022_NA0010_123_101_20220822_00010.jpg

LM Start	9.41	Rating **	M	Issue No.	101
LM End	9.45	Issue Type +	Ma	Location *	WS
Category	Earthen Levee			GPS Latitude/Longitude	
				Start	End
Item	Animal Control			37.201636 °	37.201240 °
				-120.688154 °	-120.687686 °
DWR ID	DWR_NA0010_05_s_2021_101				
Comment Code					
A3 : No rodents visible, but rodent burrows visible; need to backfill and compact or grout burrows.					
Inspector Comment

Multiple rodent holes in the waterside slope. (Spring 2021)

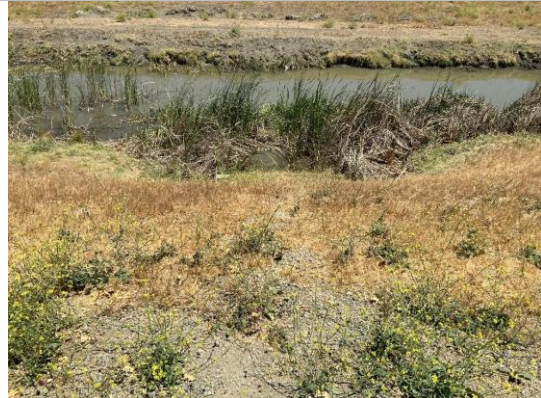
Photo 2 of 3 : UCIP_FA_2022_71010_100883.jpg

Comment Code						
Inspector Comment						
DS_ID:19767 FS_ID:71010 EP_NO: N/A Repair Type: Non-Urgent EVAL Issue: Crossing Status: Found UCIP Comments: 06/9/2021 The record remains Non-Urgent. LS pipe inlet is underwater, could not inspect. No permit was found authorizing this encroachment. CVFPB will need to review crossing to determine owner. The UCIP inspection was completed with GEI staff, P. Espinoza. (H. Dunn – GEI) 04/22/2014 Slidegate actuator appears bent and may not work properly (WS slope). (W. Wylie - DWR UCIP) FIELD_STRUCT_DESC: 24-inch corrugated metal gravity drainage pipe (CMP) through the levee, 15.0 feet below the crown. Slide gate in a 36-inch CMP riser unit on the waterside (WS) slope. Concrete headwall on each end. [Additional Reference(s): DWR Levee Log, 2002 (HLM 10.04). USACE San Joaquin O&M Manual, Unit No. 601, Part No. 1, 1967, Amended in 1978, Revised 20 June 1985, (HLM 10.05). DWR As-Built Specification No. 61-01, Sheet No. 52, 7 March 1961, (HLM 10.05)]. FS Date: 6/9/2021

LS view: Toe from crown.

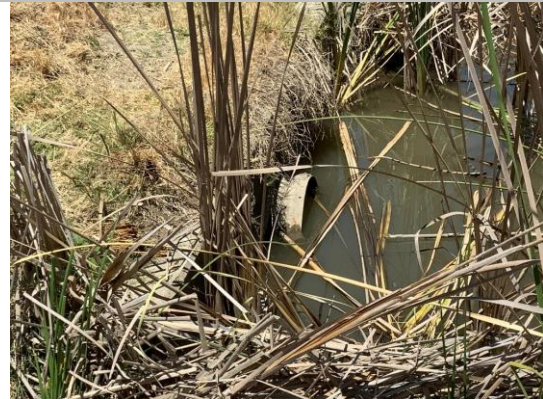
Photo 3 of 3 : UCIP_FA_2022_71010_100876.jpg

LS view: Closeup of pipe inlet at toe, underwater.

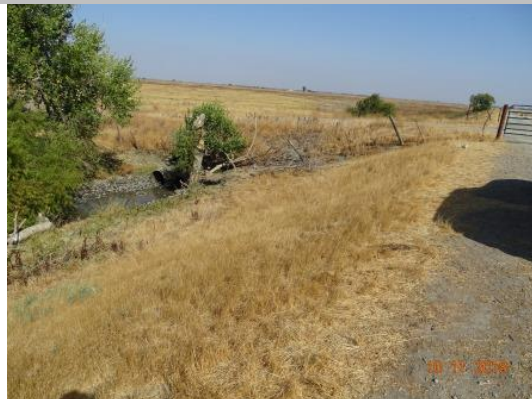
Photo 1 of 1 : FA_2022_NA0010_123_142_20220822_00037.jpg

LM Start	10.66	Rating **	M	Issue No.	142
LM End	10.66	Issue Type +	Ma	Location *	LS
Category	Earthen Levee			GPS Latitude/Longitude	
				Start	End
Item	Trim / Thin Trees			37.190286 °	37.190286 °
				-120.671207 °	-120.671207 °
DWR ID	DWR_NA0010_05_f _ 2018_142				
Comment Code					
T3 : Fallen tree with root ball.					
Inspector Comment					
A fallen tree is located on the landside toe and slope.

Fallen tree on landside toe and slope. (Fall 2018)

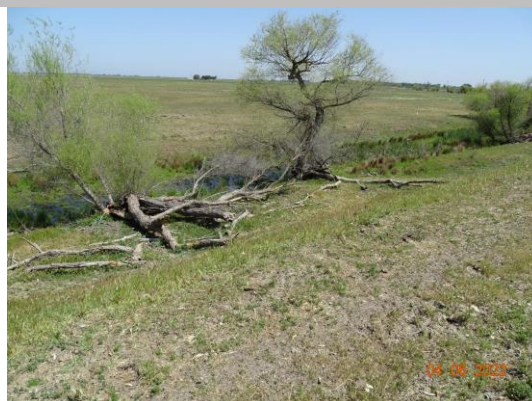
Photo 1 of 1 : FA_2022_NA0010_123_144_20220822_00038.jpg

LM Start	11.37	Rating **	M	Issue No.	144
LM End	11.37	Issue Type +	Ma	Location *	LS
Category	Earthen Levee			GPS Latitude/Longitude	
				Start	End
Item	Trim / Thin Trees			37.187792 °	37.187792 °
				-120.659454 °	-120.659454 °
DWR ID	DWR_NA0010_05_f_2018_144				
Comment Code					
T3 : Fallen tree with root ball.					
Inspector Comment					
Tree limbs on the levee slope should be trimmed to allow access.

View of tree limbs on levee slope. (Spring 2022)

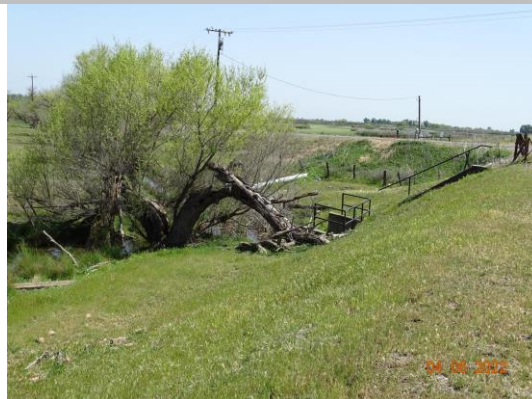
Photo 1 of 1 : FA_2022_NA0010_123_147_20220822_00040.jpg

LM Start	11.49	Rating **	U	Issue No.	147
LM End	11.49	Issue Type +	Ma	Location *	LS
Category	Earthen Levee			GPS Latitude/Longitude	
				Start	End
Item	Trim / Thin Trees			37.186482 °	37.186482 °
				-120.657935 °	-120.657935 °
DWR ID	DWR_NA0010_05_f_2021_147				
Comment Code					
T3 : Fallen tree with root ball.					
Inspector Comment					
Tree limbs are located on landside slope and toe.

Tree limbs on levee toe. (Spring 2022)

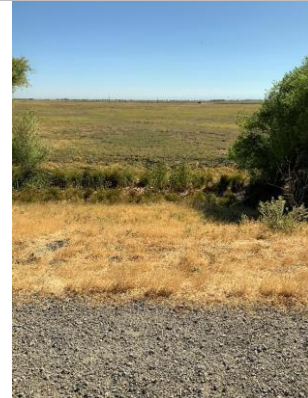
Photo 2 of 3 : UCIP_FA_2022_71012_103970.jpg

Comment Code					
Inspector Comment					
DS_ID:19768 FS_ID:71012 EP_NO: N/A Repair Type: Non-Urgent EVAL Issue: Crossing Status: Found UCIP Comments: 06/22/2021 The record has been upgraded from No Action Needed to Non-Urgent. Crossing appears to be in good condition. No permit was found authorizing this encroachment. CVFPB will need to review crossing to determine owner. The UCIP inspection was completed with GEI staff, H.Dunn. (P.Espinoza – GEI) FIELD_STRUCT_DESC: [Deadman Drain] 1 of 2: 48-inch corrugated metal gravity drainage pipe (CMP) through the levee, 16.0 feet below the crown. Slide gate in a 60-inch CMP riser unit on the waterside (WS) slope. Concrete U-shaped headwall on each end. Stairs on the landside (LS) slope. [Additional Reference(s): DWR Levee Log, 2002, (HLM 11.45). USACE San Joaquin O&M Manual, Unit No. 601, Part No. 1, 1967, Amended in 1978, Revised 20 June 1985, (HLM 11.48). DWR As-Built Specification No. 61-01, Sheet No. 53, 7 March 1961, (HLM 11.48)]. FS Date: 6/22/2021

LS view of slope from levee crown.

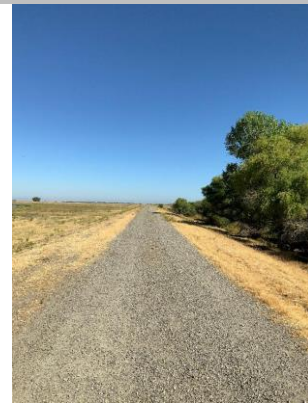
Photo 1 of 3 : UCIP_FA_2022_71013_104487.jpg

DS_ID:19734
 FS_ID:71013
 EP_NO: N/A
 Repair Type: Non-Urgent
 EVAL Issue:
 Crossing Status: Found
 UCIP Comments: 06/22/2021 The record has been upgraded from No Action Needed to Non-Urgent. Crossing appears to be in good condition. No permit was found authorizing this encroachment. CVFPB will need to review crossing to determine owner. The UCIP inspection was completed with GEI staff, P. Espinoza. (H. Dunn – GEI)
 FIELD_STRUCT_DESC: [Deadman Drain] 2 of 2: 48-inch corrugated metal gravity drainage pipe (CMP) through the levee, 16.0 feet below the crown. Slide gate in a 60-inch CMP riser unit on the waterside (WS) slope. Concrete U-shaped headwall on each end. Stairs on the landside (LS) slope. [Additional Reference(s): DWR Levee Log, 2002, (HLM 11.45). USACE San Joaquin O&M Manual, Unit No. 601, Part No. 1, 1967, Amended in 1978, Revised 20 June 1985, (HLM 11.48). DWR As-Built Specification No. 61-01, Sheet No. 53, 7 March 1961, (HLM 11.48)].

Levee crown.

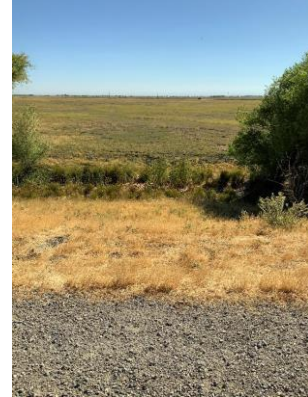
Photo 2 of 3 : UCIP_FA_2022_71013_104489.jpg

LS view: Toe from crown.

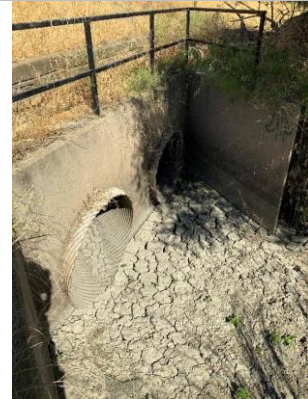
Photo 3 of 3 : UCIP_FA_2022_71013_104486.jpg

LS view: Closeup of inlet at toe.

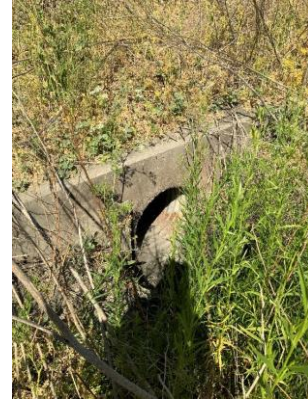
Photo 1 of 2 : UCIP_FA_2022_71015_103981.jpg

Comment Code					
Inspector Comment					
DS_ID:19704 FS_ID:71015 EP_NO: N/A Repair Type: Urgent EVAL Issue: 1, Pipe Integrity Crossing Status: Found UCIP Comments: 06/22/2021 The record has been upgraded from No Action Needed to Urgent. DWR DMP internal inspection has found pipe integrity issues. LOF of crossing is greater than or equal to 5 and less than 6. Crossing will be monitored until funding becomes available to address the issues. Limited inspection of inlet pipe due to dense vegetation; removal recommended. No permit was found authorizing this encroachment. CVFPB will need to review crossing to determine owner. The UCIP inspection was completed with GEI staff, H.Dunn. (P.Espinoza – GEI) FIELD_STRUCT_DESC: 24-inch corrugated metal gravity drainage pipe (CMP) through the levee, 11.8 feet below the crown. Flap gate on the waterside (WS) end. Concrete headwall on the landside (LS) end. Concrete saddle and apron on the WS end. [Additional Reference(s): DWR Levee Log, 2002, (HLM 11.60). USACE San Joaquin O&M Manual, Unit No. 601, Part No. 1, 1967, Amended in 1978, Revised 20 June 1985, (HLM 11.63). DWR As-Built Specification No. 61-01, Sheet No. 53, 7 March 1961, (HLM 11.63)]. FS Date: 6/22/2021

LS view: closeup of concrete headwall and inlet pipe.
