Flood Control Project Maintenance Levee Inspections

Fall 2022 Levee Maintenance Deficiency Summary Report

San Joaquin River Basin

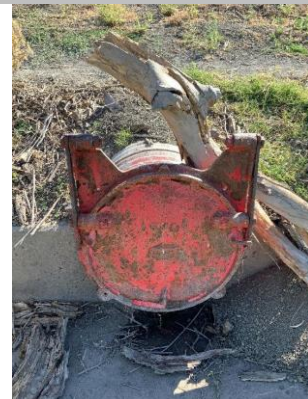
Photo 2 of 2 : UCIP_FA_2022_71015_103979.jpg

Comment Code					
Inspector Comment					
DS_ID:19704 FS_ID:71015 EP_NO: N/A Repair Type: Urgent EVAL Issue: 1, Pipe Integrity Crossing Status: Found UCIP Comments: 06/22/2021 The record has been upgraded from No Action Needed to Urgent. DWR DMP internal inspection has found pipe integrity issues. LOF of crossing is greater than or equal to 5 and less than 6. Crossing will be monitored until funding becomes available to address the issues. Limited inspection of inlet pipe due to dense vegetation; removal recommended. No permit was found authorizing this encroachment. CVFPB will need to review crossing to determine owner. The UCIP inspection was completed with GEI staff, H.Dunn. (P.Espinoza – GEI) FIELD_STRUCT_DESC: 24-inch corrugated metal gravity drainage pipe (CMP) through the levee, 11.8 feet below the crown. Flap gate on the waterside (WS) end. Concrete headwall on the landside (LS) end. Concrete saddle and apron on the WS end. [Additional Reference(s): DWR Levee Log, 2002, (HLM 11.60). USACE San Joaquin O&M Manual, Unit No. 601, Part No. 1, 1967, Amended in 1978, Revised 20 June 1985, (HLM 11.63). DWR As-Built Specification No. 61-01, Sheet No. 53, 7 March 1961, (HLM 11.63)]. FS Date: 6/22/2021

WS view: closeup of flapgate.

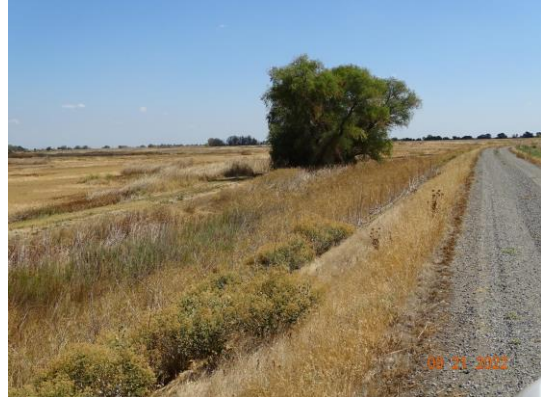
Photo 1 of 1 : FA_2022_NA0010_123_176_20221010_00365.jpg

LM Start	12.00	Rating **	M	Issue No.	176
LM End	12.30	Issue Type +	Ma	Location *	LS
Category	Earthen Levee			GPS Latitude/Longitude	
				Start	End
Item	Vegetation			37.180484 °	37.176996 °
				-120.653945 °	-120.650989 °
DWR ID	DWR_NA0010_05_f _ 2022_176				
Comment Code					
V1 : Control annual grass and weeds on the levee slopes and easements.					
Inspector Comment

View of vegetation on the landside slope and toe. (Fall 2022)

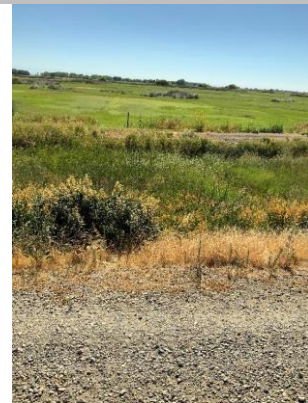
Photo 1 of 2 : UCIP_FA_2022_71016_103983.jpg

Comment Code						
Inspector Comment						
DS_ID:19705 FS_ID:71016 EP_NO: N/A Repair Type: Urgent EVAL Issue: 2b, Levee Integrity Crossing Status: Found UCIP Comments: 06/22/2021 The record has been upgraded from No Action Needed to Urgent. DWR DMP internal inspection has found pipe integrity issues. LOF of crossing is between 4.1 and 5. Crossing will be monitored until funding becomes available for rehabilitation. Limited inspection of LS due to dense vegetation; recommend removal. Erosion around concrete headwall on WS, at least 1 foot in depth. No permit was found authorizing this encroachment. CVFPB will need to review crossing to determine owner. The UCIP inspection was completed with GEI staff, H.Dunn. (P.Espinoza – GEI) FIELD_STRUCT_DESC: 24-inch corrugated metal gravity drainage pipe (CMP) through the levee, 12.5 feet below the crown. Flap gate on the waterside (WS) end. Concrete headwall on the landside (LS) end. Concrete saddle and apron on the WS end. Flashboard attachment on the LS end. [Additional Reference(s): DWR Levee Log, 2002, (HLM 11.98). USACE San Joaquin O&M Manual, Unit No. 601, Part No. 1, 1967, Amended in 1978, Revised 20 June 1985, (HLM 11.99). DWR As-Built Specification No. 61-01, Sheet No. 54, 7 March 1961, (HLM 11.99)]. FS Date: 6/22/2021

LS view: slope from crown.

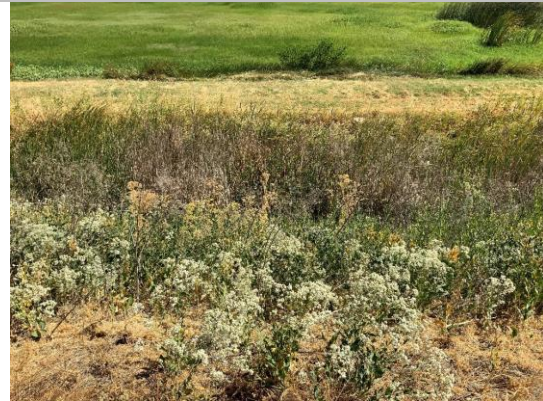
Photo 1 of 3 : UCIP_FA_2022_71017_104007.jpg

DS_ID:19706
 FS_ID:71017
 EP_NO: N/A
 Repair Type: Urgent
 EVAL Issue: 1, Pipe Integrity
 Crossing Status: Found
 UCIP Comments: 06/22/2021 The record has been upgraded from No Action Needed to Urgent. DWR DMP internal inspection has found pipe integrity issues. LOF of crossing is between 5 and 6. Crossing will be monitored until funding becomes available to address the issues. Erosion around concrete headwall on WS, at least 1 foot in length. Limited inspection of LS due to vegetation and sediment; recommend removal. No permit was found authorizing this encroachment. CVFPB will need to review crossing to determine owner. The UCIP inspection was completed with GEI staff, H.Dunn. (P.Espinoza – GEI)
 FIELD_STRUCT_DESC: 24-inch corrugated metal gravity drainage pipe (CMP) through the levee, 10.2 feet below the crown. Flap gate on the waterside (WS) end. Concrete headwall on the landside (LS) end. Concrete saddle and apron on the WS end. Flashboard attachment on the LS end. Pipe crosses levee at a 45-degree angle. [Additional Reference(s): DWR Levee Log, 2002, (HLM 12.38). USACE San Joaquin O&M Manual, Unit No. 601, Part No. 1, 1967, Amended in 1978, Revised 20 June 1985, (HLM 12.38). DWR As-Built Specification No. 61-01, Sheet No. 54, 7 March 1961, (HLM 12.38)].

LS view: Slope from crown.

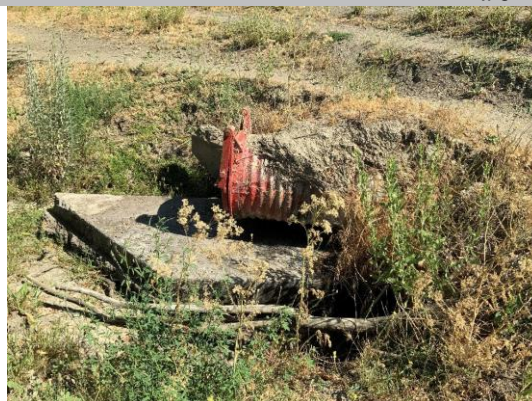
Photo 2 of 3 : UCIP_FA_2022_71017_104003.jpg

WS view: closeup of flapgate and erosion, 1 of 3 photos.

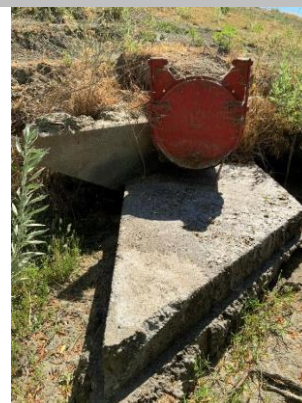
Photo 3 of 3 : UCIP_FA_2022_71017_104004.jpg

WS view: closeup of flapgate and erosion at toe, 2 of 3 photos.

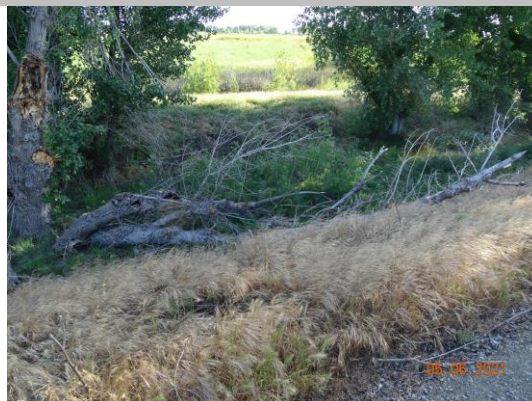
Photo 1 of 1 : FA_2022_NA0010_123_109_20220822_00014.jpg

LM Start	12.82	Rating **	U	Issue No.	109
LM End	12.82	Issue Type +	Ma	Location *	LS
Category	Earthen Levee			GPS Latitude/Longitude	
				Start	End
Item	Trim / Thin Trees			37.175814 °	37.175814 °
				-120.642171 °	-120.642171 °
DWR ID	DWR_NA0010_05_s_2021_109				
Comment Code					
T2 : Tree or limb.					
Inspector Comment

Fallen tree limbs on the landside toe and slope. (Spring 2021)

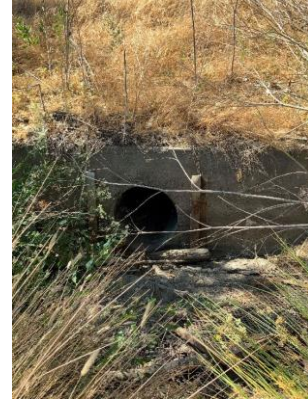
Photo 1 of 3 : UCIP_FA_2022_71018_103998.jpg

Comment Code					
Inspector Comment					
DS_ID:19707 FS_ID:71018 EP_NO: N/A Repair Type: Non-Urgent EVAL Issue: 5, Pipe Damage Crossing Status: Found UCIP Comments: 06/22/2021 The record remains Non-Urgent. DWR DMP internal inspection has found pipe integrity issues. LOF of crossing is between 4.1 and 5. Crossing will be monitored until funding becomes available for rehabilitation. Limited inspection of LS due to vegetation overgrowth; recommend removal. No permit was found authorizing this encroachment. CVFPB will need to review crossing to determine owner. The UCIP inspection was completed with GEI staff, H.Dunn. (P.Espinoza – GEI) 04/22/2014 Sediment buildup in pipe visible from landward side--recommend contacting owner to clear pipe. (W. Wylie - DWR UCIP) FIELD_STRUCT_DESC: 24-inch corrugated metal gravity drainage pipe (CMP) through the levee, 10.2 feet below the crown. Concrete headwall on the landside (LS) end with flashboards. Concrete saddle and apron on the waterside (WS) end with a flap gate. Metal screen at the LS toe inlet. [Additional Reference(s): DWR Levee Log, 2002, (HLM 12.87). USACE San Joaquin O&M Manual, Unit No. 601, Part No. 1, 1967, Amended in 1978, Revised 20 June 1985, (HLM 12.87). DWR As-Built Specification No. 61-01, Sheet No. 54, 7 March 1961, (HLM 12.87)]. FS Date: 6/22/2021

LS view: concrete headwall and inlet pipe at toe.

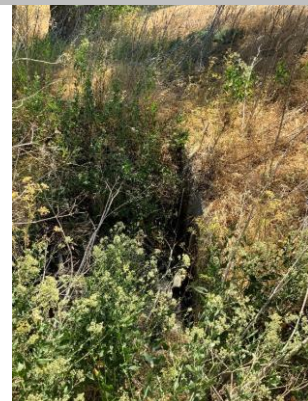
Photo 2 of 3 : UCIP_FA_2022_71018_103996.jpg

LS view: concrete headwall and inlet pipe.

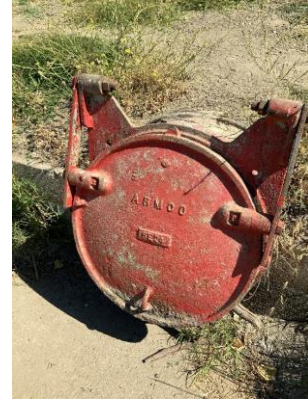
Photo 3 of 3 : UCIP_FA_2022_71018_103995.jpg

WS view: closeup of flapgate.

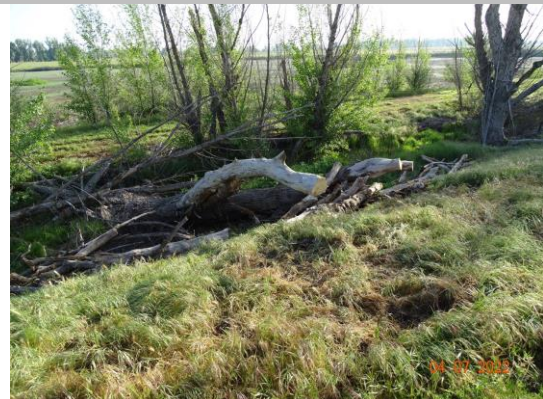
Photo 1 of 1 : FA_2022_NA0010_123_2_20220822_00003.jpg

LM Start	12.99	Rating **	U	Issue No.	2
LM End	13.01	Issue Type +	Ma	Location *	LS
Category	Earthen Levee			GPS Latitude/Longitude	
				Start	End
Item	Trim / Thin Trees			37.175638 °	37.175576 °
				-120.639076 °	-120.638755 °
DWR ID	DWR_NA0010_05_s_2016_2				
Comment Code					
T2 : Tree or limb.					
Inspector Comment					
There are several downed trees on landside toe.

Looking west at down tree at landward toe. (Spring 2022)

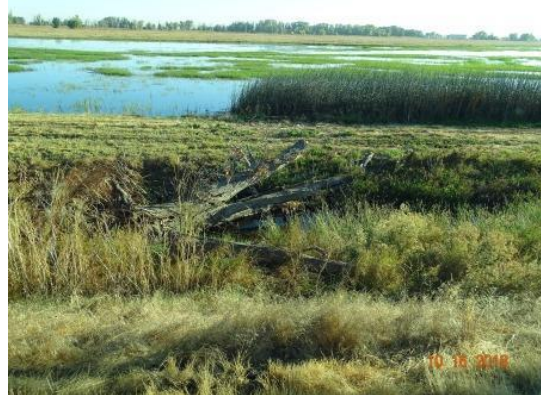
Photo 1 of 1 : FA_2022_NA0010_123_152_20220822_00043.jpg

LM Start	13.15	Rating **	M	Issue No.	152
LM End	13.15	Issue Type +	Ma	Location *	LS
Category	Earthen Levee			GPS Latitude/Longitude	
				Start	End
Item	Trim / Thin Trees			37.174444 °	37.174444 °
				-120.636589 °	-120.636589 °
DWR ID	DWR_NA0010_05_f _ 2018_152				
Comment Code					
T2 : Tree or limb.					
Inspector Comment					
There is a tree trunk on landside toe.

Tree trunk on landside toe. (Fall 2018)

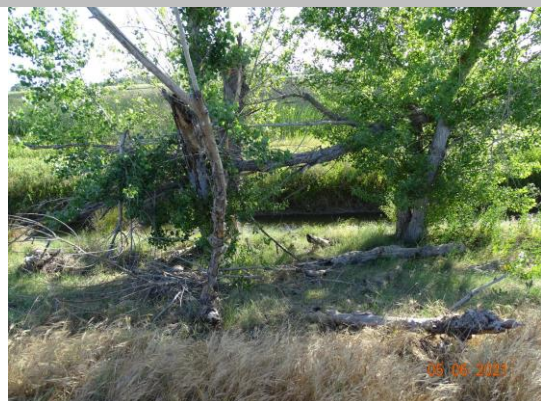
Photo 1 of 1 : FA_2022_NA0010_123_112_20220822_00016.jpg

LM Start	13.33	Rating **	U	Issue No.	112
LM End	13.37	Issue Type +	Ma	Location *	LS
Category	Earthen Levee			GPS Latitude/Longitude	
				Start	End
Item	Trim / Thin Trees			37.172473 °	37.172033 °
				-120.634470 °	-120.634005 °
DWR ID	DWR_NA0010_05_s_2021_112				
Comment Code					
T2 : Tree or limb.					
Inspector Comment

View of tree limbs on the landside toe and slope. (Spring 2021)

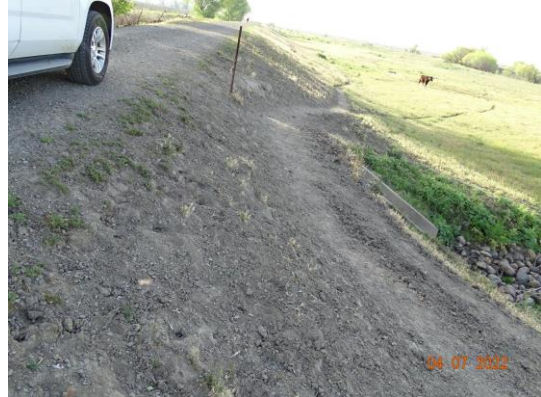
Photo 1 of 1 : FA_2022_NA0010_123_170_20220822_00057.jpg

LM Start	13.42	Rating **	U	Issue No.	170
LM End	13.42	Issue Type +	Ma	Location *	WS
Category	Earthen Levee			GPS Latitude/Longitude	
				Start	End
Item	Erosion / Livestock			37.171545 °	37.171545 °
				-120.633480 °	-120.633480 °
DWR ID	DWR_NA0010_05_s_2022_170				
Comment Code					
E4 : Repair the levee slope damaged by livestock and prevent large animal access.					
Inspector Comment

Erosion from livestock on the waterside slope around the pipe crossing.
(Spring 2022)

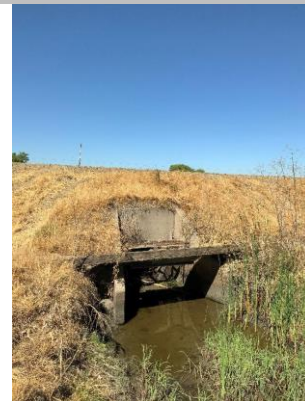
Photo 1 of 2 : UCIP_FA_2022_71019_104014.jpg

DS_ID:19708
FS_ID:71019
EP_NO: N/A
Repair Type: Non-Urgent
EVAL Issue: 11, Maintenance Compliance Issue
Crossing Status: Found
UCIP Comments: 06/22/2021 The record remains Non-Urgent. Limited inspection of LS due to water around the inlet at the time of survey. LS inlet has sediment buildup, recommend removal. No permit was found authorizing this encroachment. CVFPB will need to review crossing to determine owner. The UCIP inspection was completed with GEI staff, H.Dunn. (P.Espinoza – GEI) 04/22/2014 Some erosion around headwall on the WS toe and there are animal burrows on both slopes. (W. Wylie - DWR UCIP)
FIELD_STRUCT_DESC: 48-inch corrugated metal gravity drainage pipe (CMP) through the levee, 10.0 feet below the crown. Flap gate on the waterside (WS) end. Flashboard attachment in a concrete U-shaped headwall on the landside (LS) end. Concrete U-shaped headwall on the WS end. [Additional Reference(s): DWR Levee Log, 2002, (HLM 13.40). USACE San Joaquin O&M Manual, Unit No. 601, Part No. 1, 1967, Amended in 1978, Revised 20 June 1985, (HLM 13.40)].

LS view from toe: concrete headwall and inlet pipe. Slope visible in background.

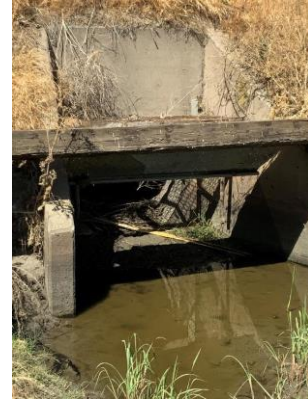
Photo 2 of 2 : UCIP_FA_2022_71019_104015.jpg

LS view from toe: closeup of concrete headwall and inlet.

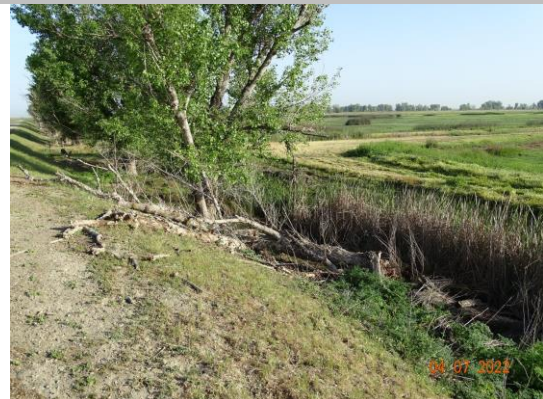
Photo 1 of 1 : FA_2022_NA0010_123_209_20220822_00064.jpg

LM Start	13.44	Rating **	U	Issue No.	209
LM End	13.44	Issue Type +	Ma	Location *	LS
Category	Earthen Levee			GPS Latitude/Longitude	
				Start	End
Item	Trim / Thin Trees			37.171249 °	37.171249 °
				-120.633157 °	-120.633157 °
DWR ID	DWR_NA0010_05_s_2020_209				
Comment Code					
T2 : Tree or limb.					
Inspector Comment					
Dead tree should be removed before it can damage the levee.

Dead tree falling over on the landside toe. (Spring 2022)

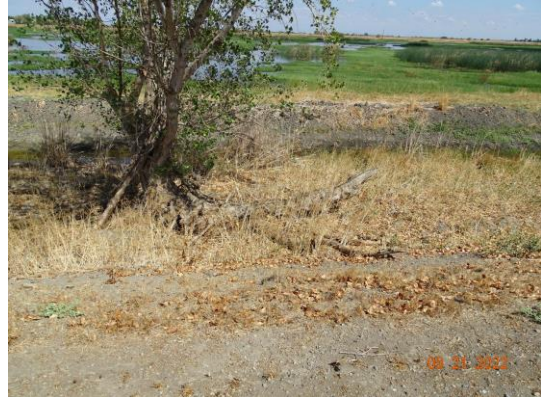
Photo 1 of 1 : FA_2022_NA0010_123_182_20221010_00367.jpg

LM Start	13.59	Rating **	M	Issue No.	182
LM End	13.59	Issue Type +	Ma	Location *	LS
Category	Earthen Levee			GPS Latitude/Longitude	
				Start	End
Item	Trim / Thin Trees			37.169572 °	37.169572 °
				-120.631384 °	-120.631384 °
DWR ID	DWR_NA0010_05_f _ 2022_182				
Comment Code					
T2 : Tree or limb.					
Inspector Comment

Broken tree limbs on the landside toe and slope. (Fall 2022)

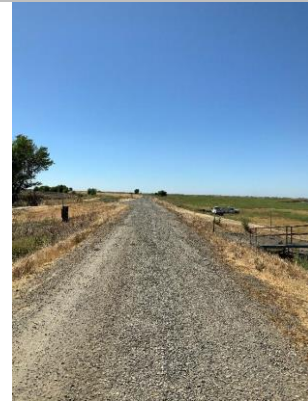
Photo 1 of 3 : UCIP_FA_2022_71020_104016.jpg

Comment Code						
Inspector Comment						
DS_ID:19709 FS_ID:71020 EP_NO: N/A Repair Type: Non-Urgent EVAL Issue: Crossing Status: Indicator Found UCIP Comments: 06/22/2021 The record remains Non-Urgent. Only LS slidegate visible, nothing seen on WS. DWR DMP geophysical study did not confirm presence of pipe through levee. Record will remain in UCIP's inspection records until future Levee Improvement Project can confirm no crossing was found through the levee. No permit was found authorizing this encroachment. CVFPB will need to review crossing to determine owner. The UCIP inspection was completed with GEI staff, H.Dunn. (P.Espinoza – GEI)04/22/2014 Pipe not visible and may need to have silt removed from outlet on WS toe. (W. Wylie - DWR UCIP) FIELD_STRUCT_DESC: 24-inch corrugated metal gravity drainage pipe (CMP) through the levee, 10.0 feet below the crown. Flap gate on the waterside (WS) end. Slide gate on a concrete headwall at the landside (LS) toe. Concrete saddle and apron on the WS end. [Additional Reference(s): DWR Levee Log, 2002, (HLM 13.70). USACE San Joaquin O&M Manual, Unit No. 601, Part No. 1, 1967, Amended in 1978, Revised 20 June 1985, (recorded as HLM 14.72, should be 13.72)]. FS Date: 6/22/2021

View of levee crown.

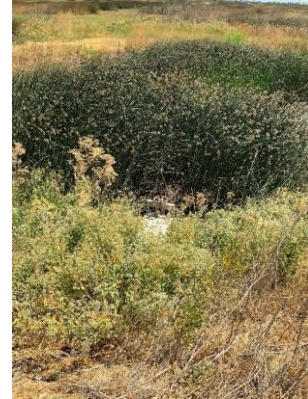
Photo 2 of 3 : UCIP_FA_2022_71020_104017.jpg

LS view of slope to toe from crown.

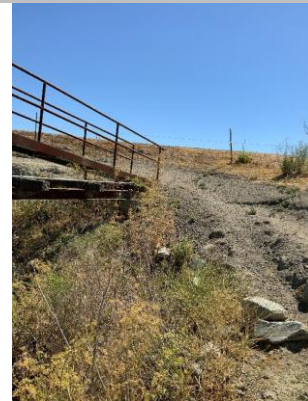
Photo 3 of 3 : UCIP_FA_2022_71020_104018.jpg

WS view of slope from toe.

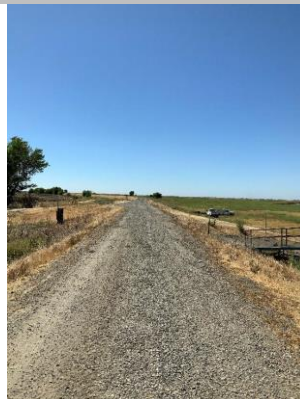
Photo 1 of 3 : UCIP_FA_2022_71021_104469.jpg

Comment Code						
Inspector Comment						
DS_ID:19566 FS_ID:71021 EP_NO: 17044 Repair Type: Non-Urgent EVAL Issue: 11, Maintenance Compliance Issue Crossing Status: Found UCIP Comments: 06/22/2021 The record has been upgraded from No Action Needed to Non-Urgent. Limited inspection of LS slidegate due to dense vegetation, recommend removal. The UCIP inspection was completed with GEI staff, P. Espinoza. (H. Dunn – GEI) FIELD_STRUCT_DESC: 2 of 2: 20-inch coated steel drainage discharge pipe through the levee, 2.0 feet below the crown. Pump station off the landside (LS) toe. Siphon breaker on the apex of the pipe on the LS shoulder. Pipe extends past waterside (WS) slope to outlet in channel. Riprap around WS pipe outlet. (Two pump stations, 24-inch steel pipe, and 20-inch steel pipe authorized under Permit No. 17044, 1999 - Merced National Wildlife Service/Ducks Unlimited, Inc.). FS Date: 6/22/2021

Levee crown.

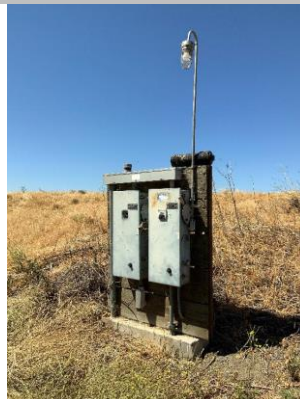
Photo 2 of 3 : UCIP_FA_2022_71021_104472.jpg

LS view: Meters on the toe.

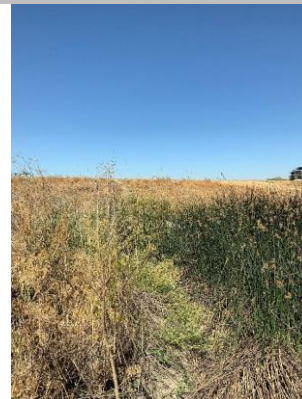
Photo 3 of 3 : UCIP_FA_2022_71021_104473.jpg

LS view: Slope from toe.

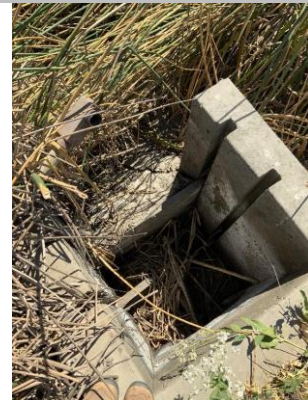
Photo 2 of 3 : UCIP_FA_2022_71023_104026.jpg

LS view: concrete wier intake structure at toe.

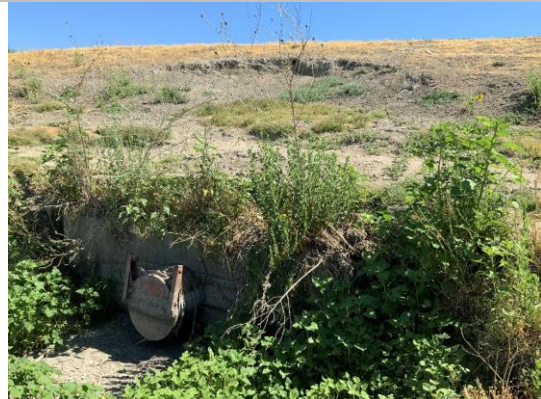
Photo 3 of 3 : UCIP_FA_2022_71023_104024.jpg

WS view from toe: concrete headwall, flapgate, and outlet pipe.
Subsidence along slope in background.

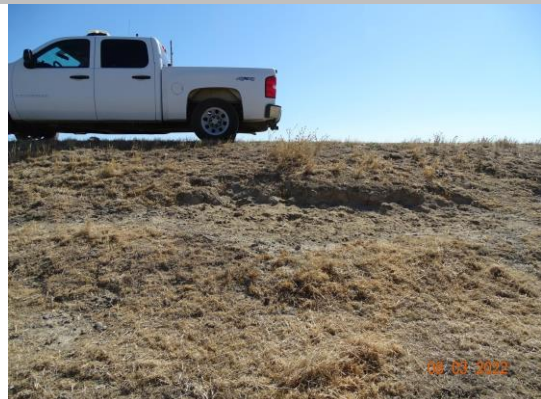
Photo 1 of 2 : SJR2022_NA0010U05RM12.22_2.JPG

Site ID: NA0010U05RM12.22
 08/03/2022: No significant changes were observed since the previous inspection.
 07/21/2021: This site was discovered during the DWR Spring 2021 Levee Inspections. There is a series of erosion pockets along the lower levee slope and toe, ranging from 3 ft in length to 15 ft and 2 ft to 7 ft in scarp height. There are several of rodent holes on the entire levee slope.

8/3/2022: Front view of the erosion.

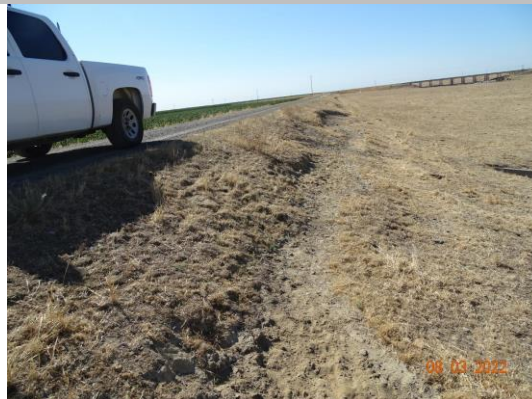
Photo 2 of 2 : SJR2022_NA0010U05RM12.22_3.JPG

8/3/2022: View of the erosion looking upstream.

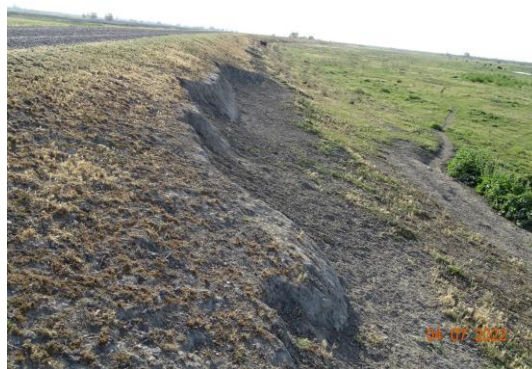
Photo 1 of 1 : FA_2022_NA0010_123_119_20220822_00021.jpg

LM Start	14.42	Rating **	U	Issue No.	119
LM End	14.49	Issue Type +	Ma	Location *	WS
Category	Earthen Levee			GPS Latitude/Longitude	
				Start	End
Item	Erosion / Bank Caving			37.162949 °	37.162540 °
				-120.619138 °	-120.618091 °
DWR ID	DWR_NA0010_05_s_2021_119				
Comment Code					
E1 : Note and monitor erosion site.					
Inspector Comment					
Slope erosion on the waterside slope. Possibly caused by livestock.

Looking upstream along the waterside slope at erosion spots. (Spring 2022)

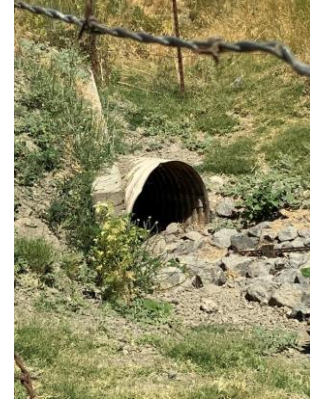
Photo 1 of 3 : UCIP_FA_2022_71025_104051.jpg

Comment Code						
Inspector Comment						
DS_ID:19712 FS_ID:71025 EP_NO: N/A Repair Type: Non-Urgent EVAL Issue: 6, Levee Damage or Threat for Levee Damage Crossing Status: Found UCIP Comments: 06/22/2021 The record remains Non-Urgent. Limited inspection on LS due to barbed wire and access issues. Build up of sediment at WS outlet pipe and LS inlet pipe; recommend removal. Some erosion along the WS slope, less than 1 foot. No permit was found authorizing this encroachment. CVFPB will need to review crossing to determine owner. The UCIP inspection was completed with GEI staff, H.Dunn. (P.Espinoza – GEI) 04/23/2014 Minor erosion at headwall on WS toe. (W. Wylie - DWR UCIP) FIELD_STRUCT_DESC: 36-inch corrugated metal gravity drainage pipe (CMP) through the levee, 11.9 feet below the crown. Flap gate on the waterside (WS) end. Concrete headwall on each end. [Additional Reference(s): DWR Levee Log, 2002, (HLM 15.08). USACE San Joaquin O&M Manual, Unit No. 601, Part No. 1, 1967, Amended in 1978, Revised 20 June 1985, (HLM 15.09)]. FS Date: 6/22/2021

LS view: Closeup of inlet pipe.

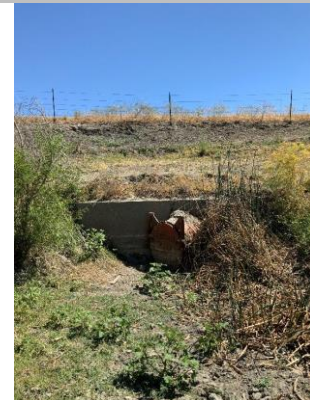
Photo 2 of 3 : UCIP_FA_2022_71025_104048.jpg

WS view from toe: concrete headwall, flapgate, and outlet pipe. Erosion along slope visible in background.

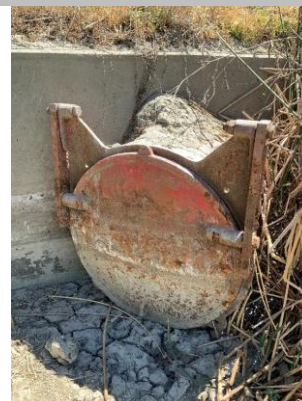
Photo 3 of 3 : UCIP_FA_2022_71025_104049.jpg

WS view from toe: closeup of flapgate and outlet pipe.

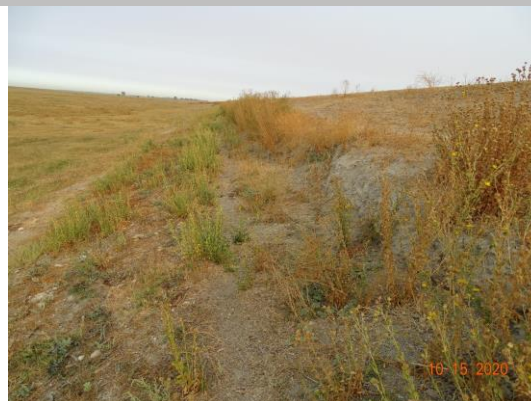
Photo 1 of 1 : FA_2022_NA0010_123_110_20220822_00015.jpg

LM Start	15.21	Rating **	M	Issue No.	110
LM End	15.26	Issue Type +	Ma	Location *	WS
Category	Earthen Levee			GPS Latitude/Longitude	
				Start	End
Item	Erosion / Bank Caving			37.155782 °	37.155337 °
				-120.608075 °	-120.607449 °
DWR ID	DWR_NA0010_05_f_2020_110				
Comment Code					
E2 : Schedule repair of erosion site prior to the next inspection.					
Inspector Comment

Erosion along the waterside slope. (Fall 2020)

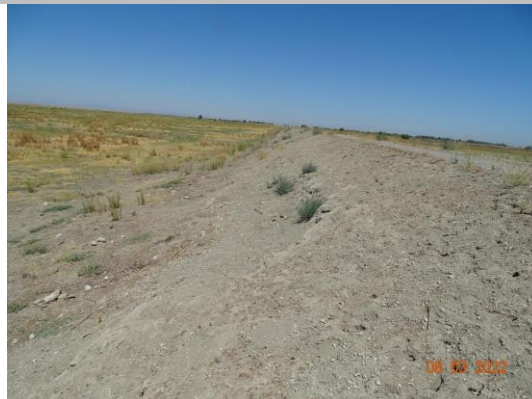
Photo 1 of 2 : SJR2022_NA0010U05RM13.09_2.JPG

LM Start	15.30	Rating **	M	Issue No.	177	
LM End	15.32	Issue Type +	Ma	Location *		
Category	Supplemental			GPS Latitude/Longitude		
				Start	End	
Item	DWR Erosion Survey			37.154837 °	37.154837 °	
				-120.606737 °	-120.606737 °	
DWR ID	NA0010U05RM13.09					
Comment Code						
Inspector Comment						
Site ID: NA0010U05RM13.09 08/03/2022: From 2021 to present, no significant changes were observed during the annual survey. The erosion length was updated to 80 ft based on more accurate field measurements. 08/19/2020: This site was discovered during the DWR Spring 2020 Levee Inspections. There is a 20-ft long and an 8-ft long erosion pocket, with scarp heights of up to 3 ft. The erosion has cut into the levee prism. There are signs of rodent and cattle activity.

8/3/2022: View of the erosion looking downstream.

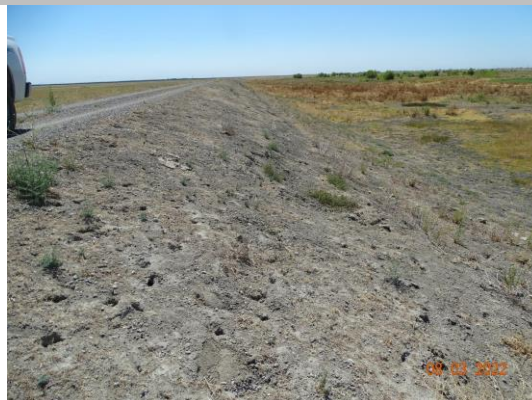
Photo 2 of 2 : SJR2022_NA0010U05RM13.09_3.JPG

8/3/2022: View of the erosion looking upstream.

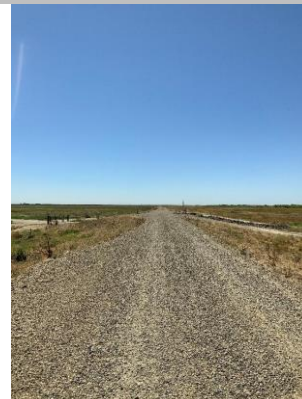
Photo 1 of 3 : UCIP_FA_2022_71026_104037.jpg

Comment Code						
Inspector Comment						
DS_ID:19713 FS_ID:71026 EP_NO: N/A Repair Type: Non-Urgent EVAL Issue: Crossing Status: Found UCIP Comments: 06/22/2021 The record remains Non-Urgent. Crossing appears to be in good condition. No permit was found authorizing this encroachment. CVFPB will need to review crossing to determine owner. The UCIP inspection was completed with GEI staff, H.Dunn. (P.Espinoza – GEI) 04/23/2014 Sediment buildup in pipe visible from landward side--recommend contacting owner to clear pipe. (W. Wylie - DWR UCIP) FIELD_STRUCT_DESC: 24-inch corrugated metal gravity drainage pipe (CMP) through the levee, 11.0 feet below the crown. Flap gate on the waterside (WS) end. Concrete headwall on each end. [Additional Reference(s): DWR Levee Log, 2002, (HLM 15.74). USACE San Joaquin O&M Manual, Unit No. 601, Part No. 1, 1967, Amended in 1978, Revised 20 June 1985, (HLM 15.74)]. FS Date: 6/22/2021

View from levee crown.

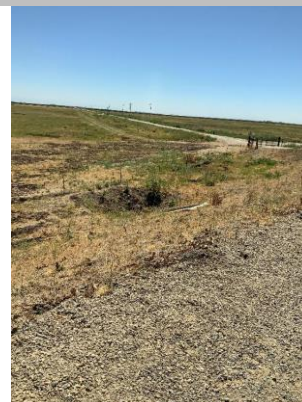
Photo 2 of 3 : UCIP_FA_2022_71026_104039.jpg

LS view of slope to toe from crown.

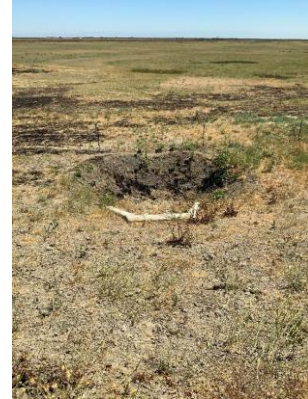
Photo 3 of 3 : UCIP_FA_2022_71026_104042.jpg

LS view of slope to toe. Concrete headwall visible at toe.

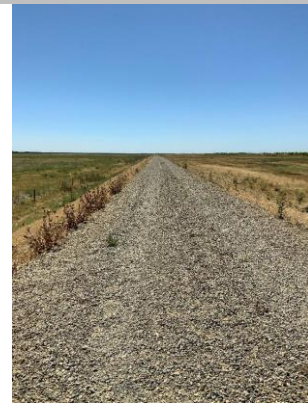
Photo 1 of 3 : UCIP_FA_2022_71028_104057.jpg

DS_ID:19715
 FS_ID:71028
 EP_NO: N/A
 Repair Type: Non-Urgent
 EVAL Issue:
 Crossing Status: Found
 UCIP Comments: 06/22/2021 The record remains Non-Urgent.
 Crossing appears to be in good condition. No permit was found authorizing this encroachment. CVFPB will need to review crossing to determine owner. The UCIP inspection was completed with GEI staff, H.Dunn. (P.Espinoza – GEI) 04/23/2014 Excess vegetation at inlet on LS toe should be cleared. (W. Wylie - DWR UCIP)
 FIELD_STRUCT_DESC: 24-inch corrugated metal gravity drainage pipe (CMP) through the levee, 12.0 feet below the crown. Flap gate on the waterside (WS) end. Concrete headwall on the landside (LS) end. Concrete saddle and apron on the WS end. [Additional Reference(s): DWR Levee Log, 2002, (HLM 15.79). USACE San Joaquin O&M Manual, Unit No. 601, Part No. 1, 1967, Amended in 1978, Revised 20 June 1985, (HLM 15.80)].
 FS Date: 6/22/2021

View from levee crown.

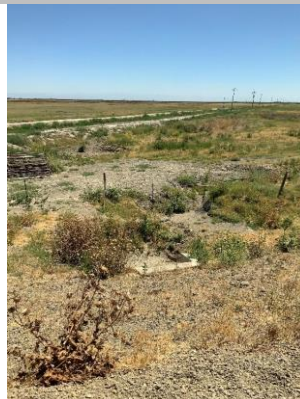
Photo 2 of 3 : UCIP_FA_2022_71028_104056.jpg

LS view of slope to toe from crown. Concrete headwall visible at toe.

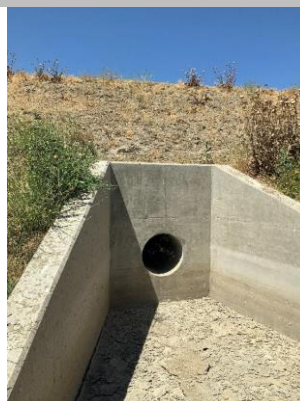
Photo 3 of 3 : UCIP_FA_2022_71028_104061.jpg

LS view from toe: concrete headwall and inlet. Slope visible in background.

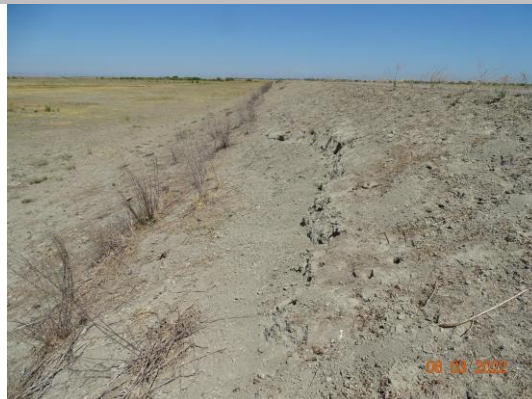
Photo 1 of 2 : SJR2022_NA0010U05RM13.85_2.JPG

Comment Code					
Inspector Comment					
Site ID: NA0010U05RM13.85 08/03/2022: The scarp height was updated to 3 ft and there is less vegetation cover than previously. 08/19/2020: Due to ongoing construction both up and downstream, this site could not be accessed and only be viewed from the opposite bank across the bypass. Unable to determine if the conditions changed since the previous inspection. 09/10/2019: The erosion has become worse during the past 2 flood seasons. The erosion length has increased to approximately 200 ft from 55 ft. Signs of animal activity were observed. 09/20/2017: The erosion was discovered during spring levee inspection. The site is covered by dense vegetation and the measurements of the erosion are estimated.

8/3/2022: View of the erosion looking downstream.

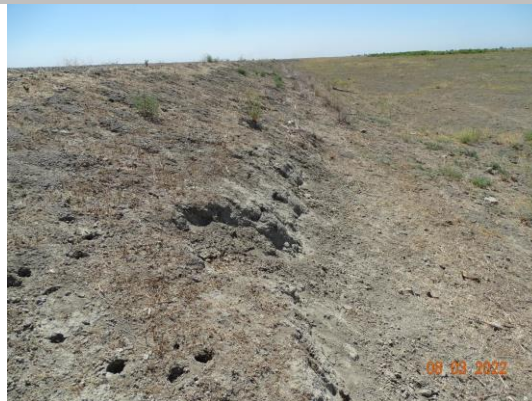
Photo 2 of 2 : SJR2022_NA0010U05RM13.85_3.JPG

8/3/2022: View of the erosion and rodent holes looking upstream.

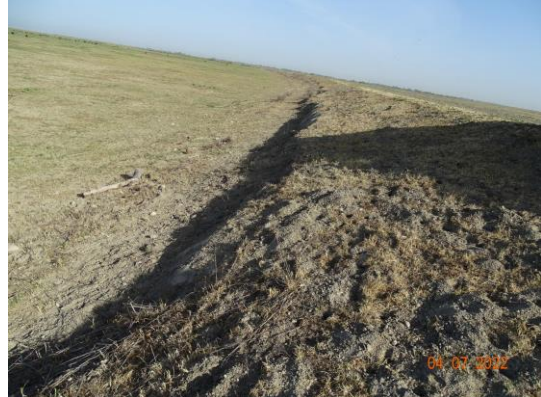
Photo 1 of 1 : FA_2022_NA0010_123_173_20220822_00059.jpg

LM Start	16.34	Rating **	M	Issue No.	173
LM End	16.34	Issue Type +	Ma	Location *	WS
Category	Earthen Levee			GPS Latitude/Longitude	
				Start	End
Item	Erosion / Livestock			37.143141 °	37.143141 °
				-120.595183 °	-120.595183 °
DWR ID	DWR_NA0010_05_s_2022_173				
Comment Code					
E4 : Repair the levee slope damaged by livestock and prevent large animal access.					
Inspector Comment

Looking downstream along the waterside slope at erosion from livestock activity. (Spring 2022)

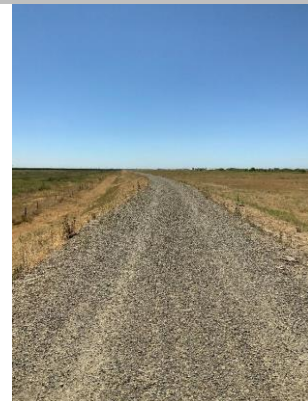
Photo 1 of 3 : UCIP_FA_2022_71029_104063.jpg

DS_ID:19716
 FS_ID:71029
 EP_NO: N/A
 Repair Type: Non-Urgent
 EVAL Issue:
 Crossing Status: Found
 UCIP Comments: 06/22/2021 The record remains Non-Urgent. Crossing appears to be in good condition. No permit was found authorizing this encroachment. CVFPB will need to review crossing to determine owner. The UCIP inspection was completed with GEI staff, H.Dunn. (P.Espinoza – GEI) 04/23/2014 Pipe heavily silted on LS toe. (W. Wylie - DWR UCIP)
 FIELD_STRUCT_DESC: 24-inch corrugated metal gravity drainage pipe (CMP) through the levee, 10.5 feet below the crown. Flap gate on the waterside (WS) end. Concrete headwall on each end. [Additional Reference(s): DWR Levee Log, 2002, (HLM 16.66). USACE San Joaquin O&M Manual, Unit No. 601, Part No. 1, 1967, Amended in 1978, Revised 20 June 1985, (HLM 16.67). DWR As-Built Specification No. 61-01, Sheet No. 57, 7 March 1961, (HLM 16.67)].
 FS Date: 6/22/2021

View from levee crown.

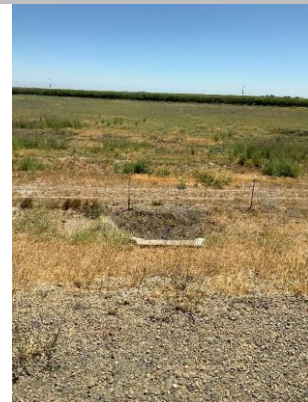
Photo 2 of 3 : UCIP_FA_2022_71030_104071.jpg

LS view of slope to toe from crown.

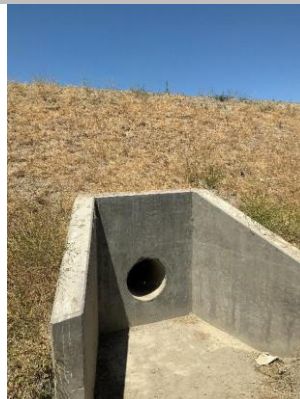
Photo 3 of 3 : UCIP_FA_2022_71030_104075.jpg

LS view at toe: concrete headwall and inlet. Slope visible in background.

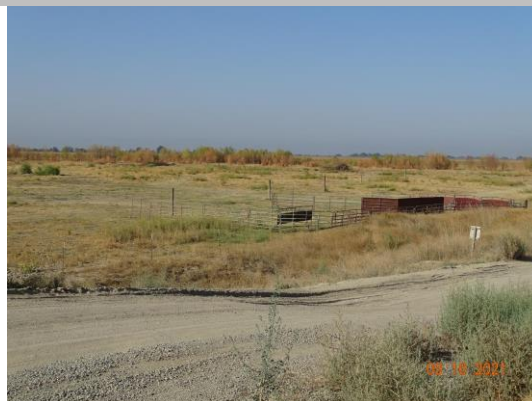
Photo 1 of 1 : FA_2022_NA0010_123_155_20220822_00046.jpg

LM Start	17.54	Rating **	M	Issue No.	155
LM End	17.54	Issue Type +	En	Location *	WS
Category	Rivers, Channels & Designated Floodways			GPS Latitude/Longitude	
				Start	End
Item	Encroachments			37.127871 °	37.127871 °
				-120.585273 °	-120.585273 °
DWR ID	DWR_NA0010_05_f_2021_155				
Comment Code					
Inspector Comment					
Livestock pen in the channel.

Landowner has put up a livestock pen within the bypass channel. (Fall 2021)

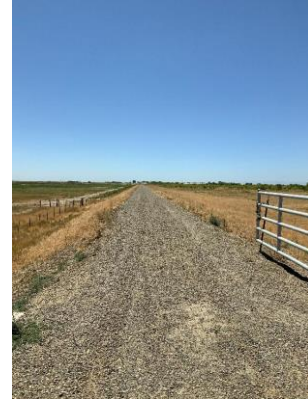
Photo 1 of 3 : UCIP_FA_2022_71031_104077.jpg

Comment Code					
Inspector Comment					
DS_ID:19743 FS_ID:71031 EP_NO: N/A Repair Type: Non-Urgent EVAL Issue: Crossing Status: Found UCIP Comments: 06/22/2021 The record remains Non-Urgent. Crossing appears to be in good condition. No permit was found authorizing this encroachment. CVFPB will need to review crossing to determine owner. The UCIP inspection was completed with GEI staff, H.Dunn. (P.Espinoza – GEI) 04/23/2014 Sediment buildup in pipe visible from landward side--recommend contacting owner to clear pipe. (W. Wylie - DWR UCIP) FIELD_STRUCT_DESC: 24-inch corrugated metal gravity drainage pipe (CMP) through the levee, 9.8 feet below the crown. Flap gate on the waterside (WS) end. Concrete headwall on each end. [Additional Reference(s): DWR Levee Log, 2002, (HLM 17.52). USACE San Joaquin O&M Manual, Unit No. 601, Part No. 1, 1967, Amended in 1978, Revised 20 June 1985, (HLM 17.52). DWR As-Built Specification No. 61-01, Sheet No. 58, 7 March 1961, (HLM 17.52)]. FS Date: 6/22/2021

View from levee crown.

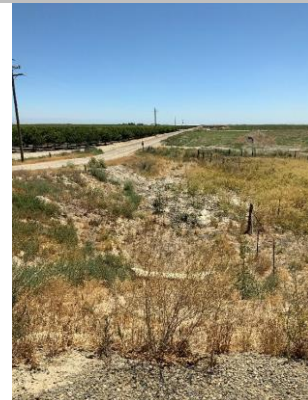
Photo 2 of 3 : UCIP_FA_2022_71031_104078.jpg

LS view of slope to toe from crown. Concrete headwall visible at toe.

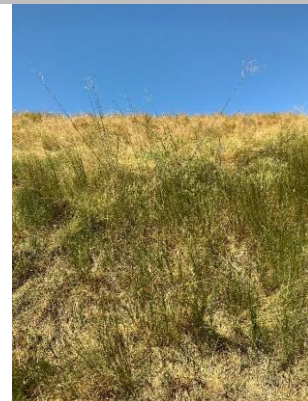
Photo 1 of 2 : UCIP_FA_2022_71033_104113.jpg

DS_ID:19745
FS_ID:71033
EP_NO: N/A
Repair Type: Non-Urgent
EVAL Issue: 11, Maintenance Compliance Issue
Crossing Status: Found
UCIP Comments: 06/22/2021 The record remains Non-Urgent. Limited inspection of LS pipe inlet due to dense vegetation, recommend removal. No permit was found authorizing this encroachment. CVFPB will need to review crossing to determine owner. The UCIP inspection was completed with GEI staff, P. Espinoza. (H. Dunn – GEI)

04/23/2014 Animal burrows in levee on both slopes. (W. Wylie - DWR UCIP)
FIELD_STRUCT_DESC: 24-inch corrugated metal gravity drainage pipe (CMP) through the levee, 12.4 feet below the crown. Flap gate on the waterside (WS) end. Concrete headwall on each end. [Additional Reference(s): DWR Levee Log, 2002, (HLM 18.07). USACE San Joaquin O&M Manual, Unit No. 601, Part No. 1, 1967, Amended in 1978, Revised 20 June 1985, (HLM 18.07). DWR As-Built Specification No. 61-01, Sheet No. 58, 7 March 1961, (HLM 18.07)].
FS Date: 6/22/2021

LS view: Slope from toe.

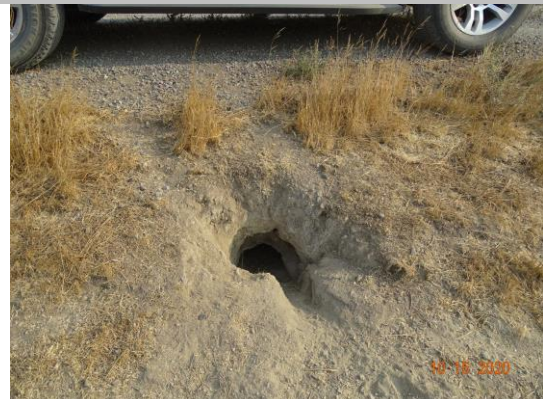
Photo 1 of 1 : FA_2022_NA0010_123_114_20220822_00018.jpg

LM Start	18.50	Rating **	U	Issue No.	114
LM End	18.50	Issue Type +	Ma	Location *	WS
Category	Earthen Levee			GPS Latitude/Longitude	
				Start	End
Item	Animal Control			37.115960 °	37.115960 °
				-120.577170 °	-120.577170 °
DWR ID	DWR_NA0010_05_f_2020_114				
Comment Code					
A3 : No rodents visible, but rodent burrows visible; need to backfill and compact or grout burrows.					
Inspector Comment					
Burrow appears to connect to hole in landside shoulder.

View of rodent burrow in the waterside shoulder. (Fall 2020)

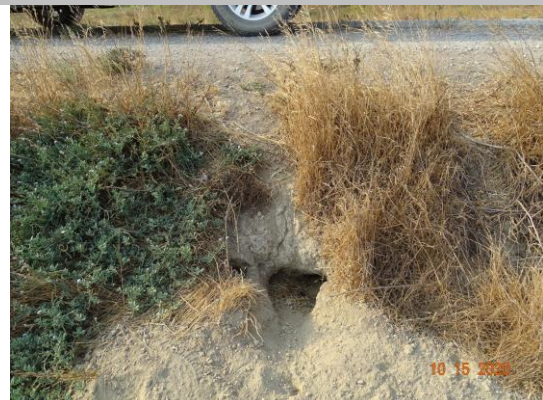
Photo 1 of 1 : FA_2022_NA0010_123_118_20220822_00020.jpg

LM Start	18.50	Rating **	U	Issue No.	118
LM End	18.50	Issue Type +	Ma	Location *	LS
Category	Earthen Levee			GPS Latitude/Longitude	
				Start	End
Item	Animal Control			37.115960 °	37.115960 °
				-120.577170 °	-120.577170 °
DWR ID	DWR_NA0010_05_f_2020_118				
Comment Code					
A3 : No rodents visible, but rodent burrows visible; need to backfill and compact or grout burrows.					
Inspector Comment					
Burrow appears to connect to hole in waterside shoulder.

Large rodent hole in the landside shoulder. (Fall 2020)

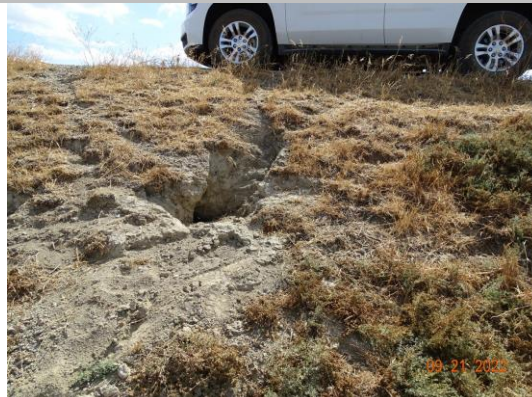
Photo 1 of 1 : FA_2022_NA0010_123_183_20221010_00368.jpg

LM Start	18.56	Rating **	U	Issue No.	183
LM End	18.56	Issue Type +	Ma	Location *	LS
Category	Earthen Levee			GPS Latitude/Longitude	
				Start	End
Item	Animal Control			37.115653 °	37.115653 °
				-120.576199 °	-120.576199 °
DWR ID	DWR_NA0010_05_f_2022_183				
Comment Code					
A3 : No rodents visible, but rodent burrows visible; need to backfill and compact or grout burrows.					
Inspector Comment

Large animal burrow on the landside slope. (Fall 2022)

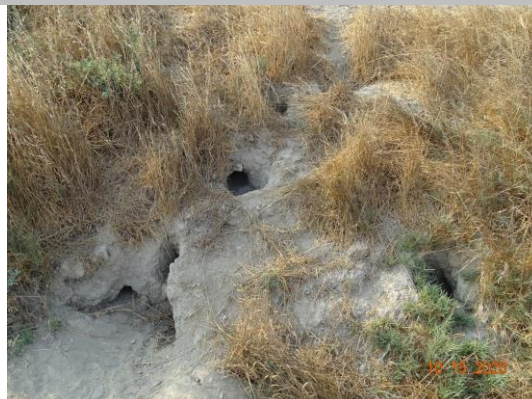
Photo 1 of 1 : FA_2022_NA0010_123_126_20220822_00026.jpg

LM Start	18.62	Rating **	U	Issue No.	126
LM End	18.62	Issue Type +	Ma	Location *	LS
Category	Earthen Levee			GPS Latitude/Longitude	
				Start	End
Item	Animal Control			37.115481 °	37.115481 °
				-120.575126 °	-120.575126 °
DWR ID	DWR_NA0010_05_f_2020_126				
Comment Code					
A3 : No rodents visible, but rodent burrows visible; need to backfill and compact or grout burrows.					
Inspector Comment

Several large rodent holes observed at this location. (Fall 2020)

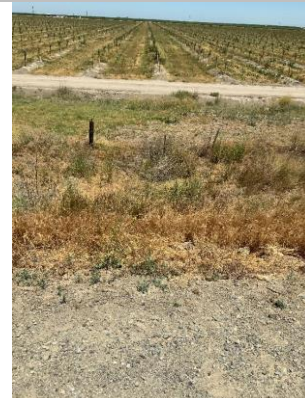
Photo 2 of 3 : UCIP_FA_2022_71034_104121.jpg

LS view: Toe from crown.

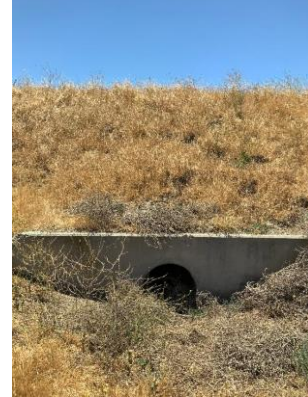
Photo 1 of 2 : UCIP_FA_2022_71035_104125.jpg

Comment Code					
Inspector Comment					
DS_ID:19747 FS_ID:71035 EP_NO: N/A Repair Type: Non-Urgent EVAL Issue: 11, Maintenance Compliance Issue Crossing Status: Found UCIP Comments: 06/22/2021 The record remains Non-Urgent. Limited inspection due to LS inlet being covered by dense tumbleweeds, recommend removal. No permit was found authorizing this encroachment. CVFPB will need to review crossing to determine owner. The UCIP inspection was completed with GEI staff, P. Espinoza. (H. Dunn – GEI) 04/23/2014 Sediment buildup in pipe visible from landward side--recommend contacting owner to clear pipe. (W. Wylie - DWR UCIP) FIELD_STRUCT_DESC: 24-inch corrugated metal gravity drainage pipe (CMP) through the levee, 10.0 feet below the crown. Flap gate on the waterside (WS) end. Concrete headwall on the landside (LS) end. Concrete U-shaped headwall on the WS end. [Additional Reference(s): DWR Levee Log, 2002, (HLM 19.13). USACE San Joaquin O&M Manual, Unit No. 601, Part No. 1, 1967, Amended in 1978, Revised 20 June 1985, (HLM 19.11). DWR As-Built Specification No. 64-01, Sheet No. 3, 6 November 1963, (HLM 19.11)]. FS Date: 6/22/2021

LS view: Slope and headwall at toe.

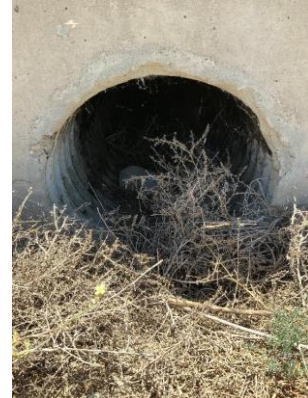
Photo 2 of 2 : UCIP_FA_2022_71035_104126.jpg

LS view: Closeup of inlet at toe.

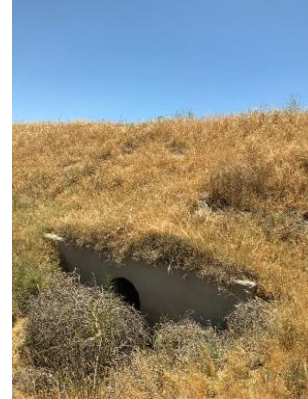
Photo 1 of 2 : UCIP_FA_2022_71036_104132.jpg

Comment Code						
Inspector Comment						
DS_ID:19776 FS_ID:71036 EP_NO: N/A Repair Type: Non-Urgent EVAL Issue: 11, Maintenance Compliance Issue Crossing Status: Found UCIP Comments: 06/22/2021 The record has been upgraded from No Action Needed to Non-Urgent. Some tumbleweed buildup around LS inlet, recommend removal. No permit was found authorizing this encroachment. CVFPB will need to review crossing to determine owner. The UCIP inspection was completed with GEI staff, P. Espinoza. (H. Dunn – GEI) FIELD_STRUCT_DESC: 24-inch corrugated metal gravity drainage pipe (CMP) through the levee, 10.3 feet below the crown. Flap gate on the waterside (WS) end. Concrete headwall on the landside (LS) end. Concrete U-shaped headwall on the WS end. [Additional Reference(s): DWR Levee Log, 2002, (HLM 19.15). USACE San Joaquin O&M Manual, Unit No. 601, Part No. 1, 1967, Amended in 1978, Revised 20 June 1985, (HLM 19.15). DWR As-Built Specification No. 64-01, Sheet No. 3, 6 November 1963, (HLM 19.15)]. FS Date: 6/22/2021

LS view: Headwall and slope from toe.

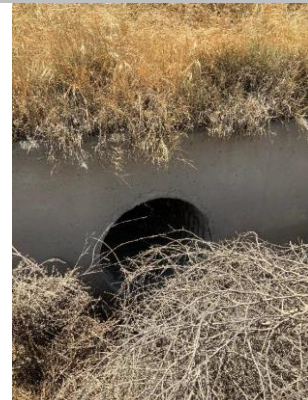
Photo 2 of 2 : UCIP_FA_2022_71036_104133.jpg

LS view: Closeup of inlet covered by tumbleweeds at toe.

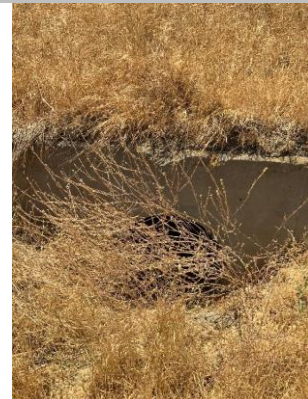
Photo 2 of 2 : UCIP_FA_2022_71037_104143.jpg

LS view: Closeup of inlet covered by vegetation at toe.

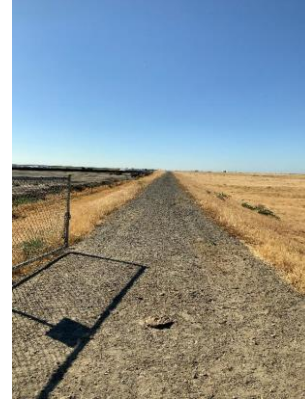
Photo 1 of 3 : UCIP_FA_2022_71039_104146.jpg

Comment Code						
Inspector Comment						
DS_ID:19778 FS_ID:71039 EP_NO: N/A Repair Type: Non-Urgent EVAL Issue: Crossing Status: Found UCIP Comments: 06/23/2021 The record remains Non-Urgent. DWR DMP internal inspection has not found pipe integrity issues. LOF of crossing is less or equal to 4.0. Recommend next video inspection in 5 years. No permit was found authorizing this encroachment. CVFPB will need to review crossing to determine owner. The UCIP inspection was completed with GEI staff, P. Espinoza. (H. Dunn – GEI) 04/23/2014 Dense vegetation limits the inspector's visibility to identify signs of pipe failure (leaks) along the landward slope. Recommend removing vegetation along pipe alignment to conduct proper inspection of structure. Sediment buildup in pipe visible from landward side-- recommend contacting owner to clear pipe. (W. Wylie - DWR UCIP) FIELD_STRUCT_DESC: 24-inch corrugated metal gravity drainage pipe (CMP) through the levee, 9.7 feet below the crown. Flap gate on the waterside (WS) end. Concrete headwall on the landside (LS) end. Concrete U-shaped headwall on the WS end. [Additional Reference(s): DWR Levee Log, 2002, (HLM 19.50). USACE San Joaquin O&M Manual, Unit No. 601, Part No. 1, 1967, Amended in 1978, Revised 20 June 1985, (HLM 19.50). DWR As-Built Specification No. 64-01, Sheet No. 3, 6 November 1963, (HLM 19.50)]. FS Date: 6/23/2021

Levee crown.

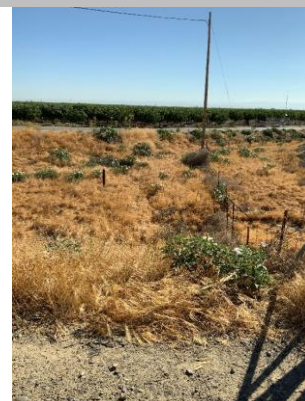
Photo 2 of 3 : UCIP_FA_2022_71039_104147.jpg

LS view: Toe from crown.

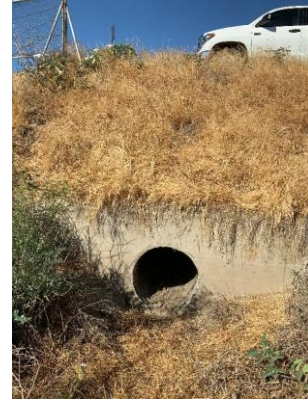
Photo 3 of 3 : UCIP_FA_2022_71039_104144.jpg

LS view: Headwall and slope at toe.

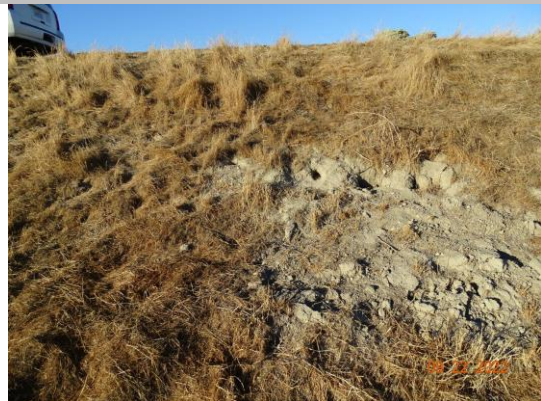
Photo 1 of 1 : FA_2022_NA0010_123_185_20221010_00370.jpg

LM Start	19.55	Rating **	M	Issue No.	185
LM End	19.55	Issue Type +	Ma	Location *	LS
Category	Earthen Levee			GPS Latitude/Longitude	
				Start	End
Item	Animal Control			37.112675 °	37.112675 °
				-120.559535 °	-120.559535 °
DWR ID	DWR_NA0010_05_f_2022_185				
Comment Code					
A3 : No rodents visible, but rodent burrows visible; need to backfill and compact or grout burrows.					
Inspector Comment

View of rodent burrows in the landside slope. (Fall 2022)

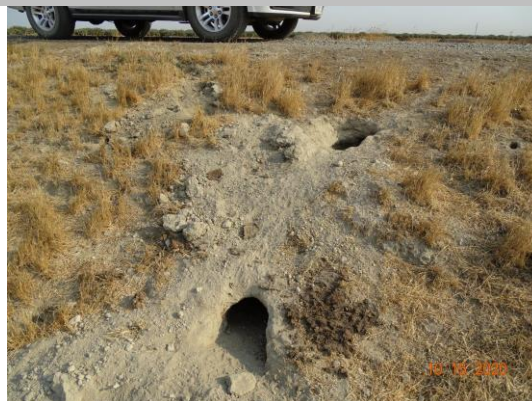
Photo 1 of 1 : FA_2022_NA0010_123_128_20220822_00028.jpg

LM Start	19.64	Rating **	U	Issue No.	128
LM End	19.64	Issue Type +	Ma	Location *	WS
Category	Earthen Levee			GPS Latitude/Longitude	
				Start	End
Item	Animal Control			37.111664 °	37.111664 °
				-120.558511 °	-120.558511 °
DWR ID	DWR_NA0010_05_f_2020_128				
Comment Code					
A3 : No rodents visible, but rodent burrows visible; need to backfill and compact or grout burrows.					
Inspector Comment

View of rodent activity on the waterside slope. (Fall 2020)

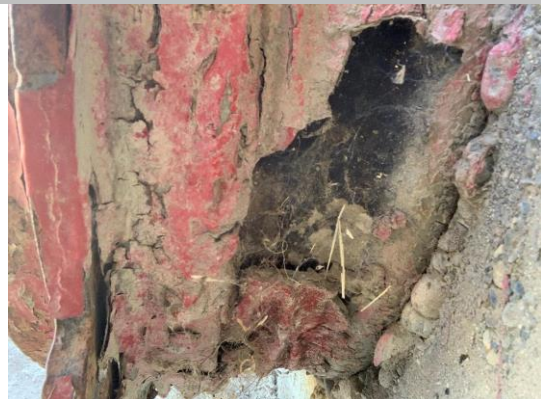
Photo 2 of 3 : UCIP_FA_2022_71040_104110.jpg

WS view: Closeup of deterioration of flapgate at toe.

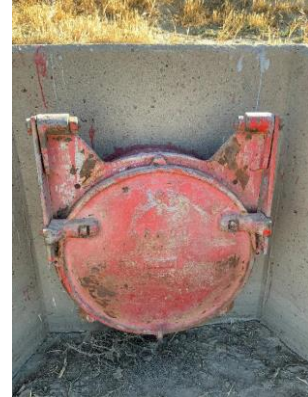
Photo 3 of 3 : UCIP_FA_2022_71040_104152.jpg

WS view: Closeup of flapgate at toe.

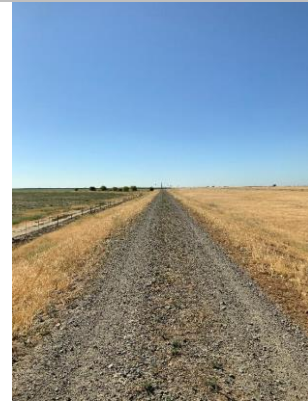
Photo 1 of 3 : UCIP_FA_2022_71041_104156.jpg

DS_ID:19780
 FS_ID:71041
 EP_NO: N/A
 Repair Type: Non-Urgent
 EVAL Issue:
 Crossing Status: Found
 UCIP Comments: 06/23/2021 The record has been upgraded from No Action Needed to Non-Urgent. DWR DMP internal inspection has not found pipe integrity issues. LOF of crossing is less or equal to 4.0. Recommend next video inspection in 5 years. No permit was found authorizing this encroachment. CVFPB will need to review crossing to determine owner. The UCIP inspection was completed with GEI staff, P. Espinoza. (H. Dunn – GEI)
 FIELD_STRUCT_DESC: 36-inch corrugated metal gravity drainage pipe (CMP) through the levee, 9.8 feet below the crown. Flap gate on the waterside (WS) end. Concrete headwall on the landside (LS) end. Concrete U-shaped headwall on the WS end. [Additional Reference(s): DWR Levee Log, 2002, (HLM 19.92). USACE San Joaquin O&M Manual, Unit No. 601, Part No. 1, 1967, Amended in 1978, Revised 20 June 1985, (HLM 19.92). DWR As-Built Specification No. 64-01, Sheet No. 4, 6 November 1963, (HLM 19.92)].

Levee crown.

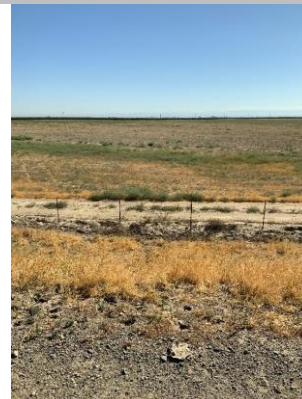
Photo 2 of 3 : UCIP_FA_2022_71041_104157.jpg

LM Start	19.94	Rating **	M	Issue No.	1357 (cont)
LM End	19.94	Issue Type +	Ma	Location *	
Category	Supplemental			GPS Latitude/Longitude	
				Start	End
Item	DWR UCIP LMA Responsibility			37.108426 °	37.108426 °
				-120.554990 °	-120.554990 °
DWR ID	19780

LS view: Toe from crown.

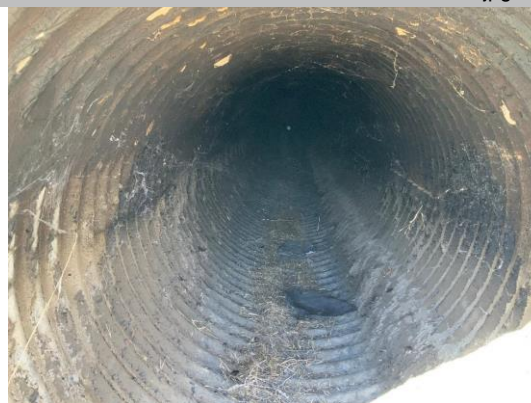
Photo 3 of 3 : UCIP_FA_2022_71041_104155.jpg

LS view: Inside pipe inlet at toe.

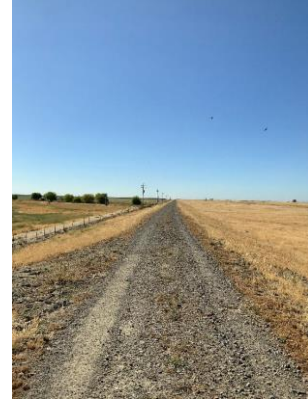
Photo 1 of 3 : UCIP_FA_2022_71042_104163.jpg

Comment Code					
Inspector Comment					
DS_ID:19781 FS_ID:71042 EP_NO: N/A Repair Type: Non-Urgent EVAL Issue: Crossing Status: Found UCIP Comments: 06/23/2021 The record has been upgraded from No Action Needed to Non-Urgent. DWR DMP internal inspection has not found pipe integrity issues. LOF of crossing is less or equal to 4.0. Recommend next video inspection in 5 years. No permit was found authorizing this encroachment. CVFPB will need to review crossing to determine owner. The UCIP inspection was completed with GEI staff, P. Espinoza. (H. Dunn – GEI) FIELD_STRUCT_DESC: 36-inch corrugated metal gravity drainage pipe (CMP) through the levee, 9.9 feet below the crown. Flap gate on the waterside (WS) end. Concrete headwall on the landside (LS) end. Concrete U-shaped headwall on the WS end. [Additional Reference(s): DWR Levee Log, 2002, (HLM 20.04). USACE San Joaquin O&M Manual, Unit No. 601, Part No. 1, 1967, Amended in 1978, Revised 20 June 1985, (HLM 20.05). DWR As-Built Specification No. 64-01, Sheet No. 4, 6 November 1963, (HLM 20.05)]. FS Date: 6/23/2021

Levee crown.

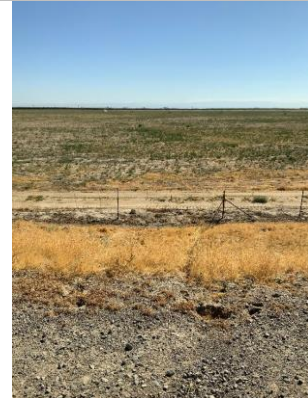
Photo 2 of 3 : UCIP_FA_2022_71042_104164.jpg

LS view: Toe from crown.

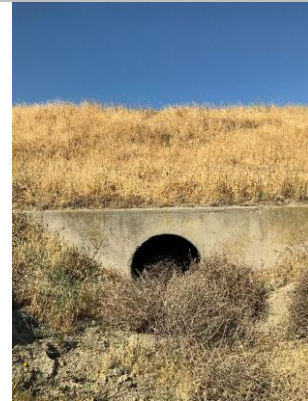
Photo 1 of 2 : UCIP_FA_2022_71043_104168.jpg

DS_ID:19783
 FS_ID:71043
 EP_NO: N/A
 Repair Type: Non-Urgent
 EVAL Issue: 11, Maintenance Compliance Issue
 Crossing Status: Found
 UCIP Comments: 06/23/2021 The record has been upgraded from No Action Needed to Non-Urgent. DWR DMP internal inspection has not found pipe integrity issues. LOF of crossing is less or equal to 4.0. Recommend next video inspection in 5 years. Limited inspection of LS pipe inlet due to tumbleweeds, recommend removal. No permit was found authorizing this encroachment. CVFPB will need to review crossing to determine owner. The UCIP inspection was completed with GEI staff, P. Espinoza. (H. Dunn – GEI)
 FIELD_STRUCT_DESC: 36-inch corrugated metal gravity drainage pipe (CMP) through the levee, 10.6 feet below the crown. Flap gate on the waterside (WS) end. Concrete headwall on each end. [Additional Reference(s): DWR Levee Log, 2002, (HLM 20.18). USACE San Joaquin O&M Manual, Unit No. 601, Part No. 1, 1967, Amended in 1978, Revised 20 June 1985, (HLM 20.18). DWR As-Built Specification No. 64-01, Sheet No. 4, 6 November 1963, (HLM 20.18)].

LS view: Slope and headwall from toe.

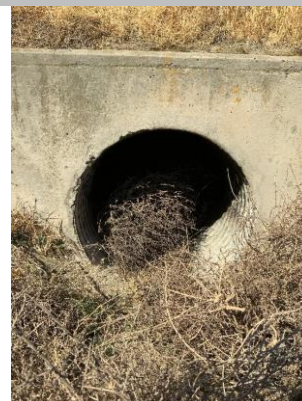
Photo 2 of 2 : UCIP_FA_2022_71043_104169.jpg

LS view: Closeup of pipe inlet at toe.
