Flood Control Project Maintenance Levee Inspections

Fall 2022 Levee Maintenance Deficiency Summary Report

San Joaquin River Basin

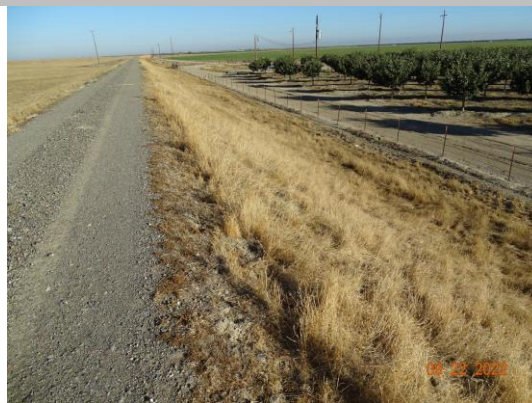
Photo 1 of 1 : FA_2022_NA0010_123_186_20221010_00371.jpg

LM Start	20.38	Rating **	M	Issue No.	186
LM End	23.24	Issue Type +	Ma	Location *	LS
Category	Earthen Levee			GPS Latitude/Longitude	
				Start	End
Item	Vegetation			37.103960 °	37.073142 °
				-120.550348 °	-120.516854 °
DWR ID	DWR_NA0010_05_f_2022_186				
Comment Code					
V1 : Control annual grass and weeds on the levee slopes and easements.					
Inspector Comment

Looking downstream along the landside slope. (Fall 2022)

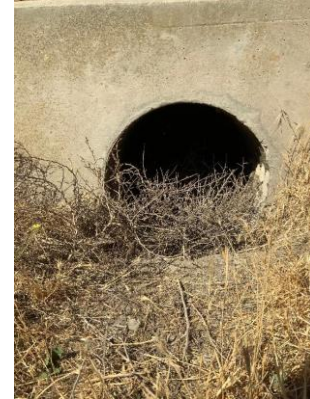
Photo 1 of 1 : UCIP_FA_2022_71044_104180.jpg

Comment Code					
Inspector Comment					
DS_ID:19784 FS_ID:71044 EP_NO: N/A Repair Type: Urgent EVAL Issue: 1, Pipe Integrity Crossing Status: Found UCIP Comments: 06/23/2021 The record has been upgraded from Non-Urgent to Urgent. DWR DMP internal inspection has found pipe integrity issues. LOF of crossing is greater than or equal to 5 and less than 6. Crossing will be monitored until funding becomes available to address the issues. Some tumbleweed buildup at LS pipe inlet, recommend removal. No permit was found authorizing this encroachment. CVFPB will need to review crossing to determine owner. The UCIP inspection was completed with GEI staff, P. Espinoza. (H. Dunn – GEI)04/23/2014 Dense vegetation limits the inspector's visibility to identify signs of pipe failure (leaks) along the landward slope. Recommend removing vegetation along pipe alignment to conduct proper inspection of structure. (W. Wylie - DWR UCIP) FIELD_STRUCT_DESC: 24-inch corrugated metal gravity drainage pipe (CMP) through the levee, 10.5 feet below the crown. Flap gate on the waterside (WS) end. Concrete headwall on the landside (LS) end. Concrete U-shaped headwall on the WS end. [Additional Reference(s): DWR Levee Log, 2002, (HLM 20.58). USACE San Joaquin O&M Manual, Unit No. 601, Part No. 1, 1967, Amended in 1978, Revised 20 June 1985, (HLM 20.59). DWR As-Built Specification No. 64-01, Sheet No. 4, 6 November 1963, (HLM 20.59)]. FS Date: 6/23/2021

LS view: Tumbleweeds in pipe inlet at toe.

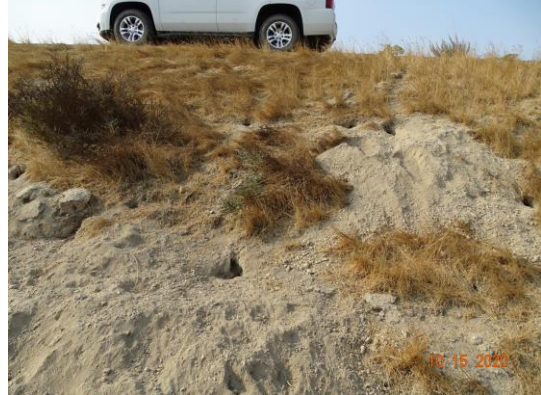
Photo 1 of 1 : FA_2022_NA0010_123_135_20220822_00033.jpg

LM Start	20.93	Rating **	M	Issue No.	135
LM End	20.93	Issue Type +	Ma	Location *	LS
Category	Earthen Levee			GPS Latitude/Longitude	
				Start	End
Item	Animal Control			37.097826 °	37.097826 °
				-120.543984 °	-120.543984 °
DWR ID	DWR_NA0010_05_f _ 2020_135				
Comment Code					
A3 : No rodents visible, but rodent burrows visible; need to backfill and compact or grout burrows.					
Inspector Comment

View of rodent burrow in the landside slope. (Fall 2020)

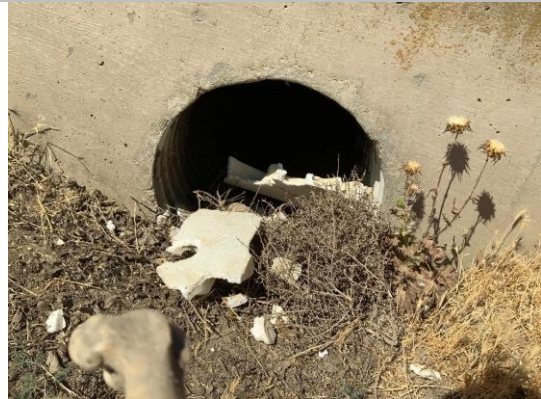
Photo 1 of 2 : UCIP_FA_2022_71045_104182.jpg

DS_ID:19785
FS_ID:71045
EP_NO: N/A
Repair Type: Urgent
EVAL Issue: 1, Pipe Integrity
Crossing Status: Found
UCIP Comments: 06/23/2021 The record is being upgraded from Non-Urgent to Urgent. DWR DMP internal inspection has found pipe integrity issues. LOF of crossing is is greater than or equal to 5 and less than 6. Crossing will be monitored until funding becomes available to address the issues. Tumbleweed and debris covering LS pipe inlet, recommend removal. No permit was found authorizing this encroachment. CVFPB will need to review crossing to determine owner. The UCIP inspection was completed with GEI staff, P. Espinoza. (H. Dunn – GEI)04/23/2014 Dense vegetation limits the inspector's visibility to identify signs of pipe failure (leaks) along the landward slope. Recommend removing vegetation along pipe alignment to conduct proper inspection of structure. (W. Wylie - DWR UCIP)
FIELD_STRUCT_DESC: 24-inch corrugated metal gravity drainage pipe (CMP) through the levee, 11.8 feet below the crown. Flap gate on the waterside (WS) end. Concrete headwall on the landside (LS) end. Concrete U-shaped headwall on the WS end. [Additional Reference(s): DWR Levee Log, 2002, (HLM 21.07). USACE San Joaquin O&M Manual, Unit No. 601, Part No. 1, 1967, Amended in 1978, Revised 20 June 1985, (HLM 21.08). DWR As-Built Specification No. 64-01, Sheet No. 5, 6 November 1963, (HLM 21.08)].

LS view: Debris inside pipe inlet at toe.

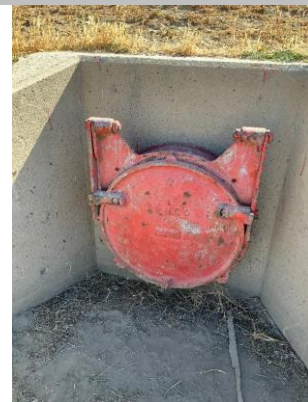
Photo 2 of 2 : UCIP_FA_2022_71045_104187.jpg

WS view: Closeup of flapgate at toe.

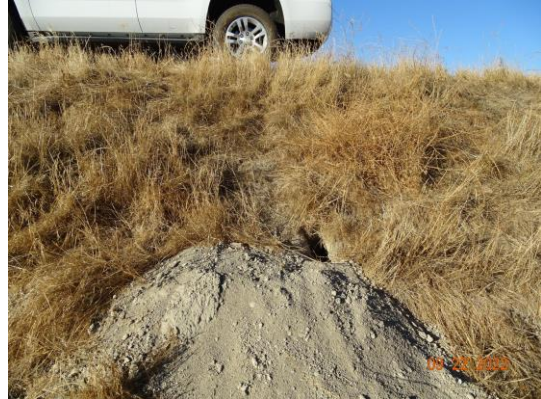
Photo 1 of 1 : FA_2022_NA0010_123_187_20221010_00372.jpg

LM Start	21.32	Rating **	M	Issue No.	187
LM End	21.32	Issue Type +	Ma	Location *	LS
Category	Earthen Levee			GPS Latitude/Longitude	
				Start	End
Item	Animal Control			37.093578 °	37.093578 °
				-120.539403 °	-120.539403 °
DWR ID	DWR_NA0010_05_f _ 2022_187				
Comment Code					
A3 : No rodents visible, but rodent burrows visible; need to backfill and compact or grout burrows.					
Inspector Comment

View of a rodent burrow on the landside slope. (Fall 2022).

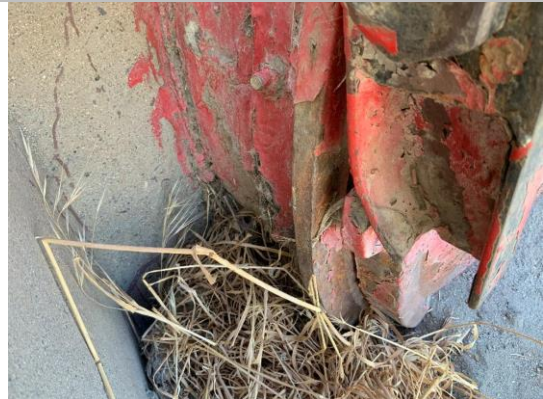
Photo 2 of 3 : UCIP_FA_2022_71046_104188.jpg

WS view: Closeup of potential gap in flapgate at toe.

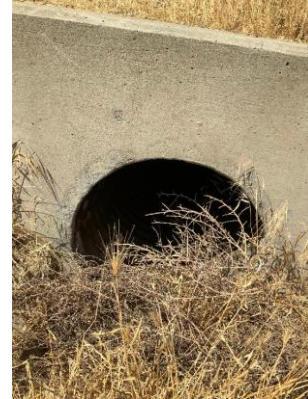
Photo 1 of 2 : UCIP_FA_2022_71049_104210.jpg

Comment Code					
Inspector Comment					
DS_ID:19789 FS_ID:71049 EP_NO: N/A Repair Type: Urgent EVAL Issue: 1, Pipe Integrity Crossing Status: Found UCIP Comments: 06/23/2021 The record has been upgraded from Non-Urgent to Urgent. DWR DMP internal inspection has found pipe integrity issues. LOF of crossing is is greater than or equal to 5 and less than 6. Crossing will be monitored until funding becomes available to address the issues. Some vegetation growing over LS pipe inlet, recommend removal. No permit was found authorizing this encroachment. CVFPB will need to review crossing to determine owner. The UCIP inspection was completed with GEI staff, P. Espinoza. (H. Dunn – GEI)04/23/2014 Dense vegetation limits the inspector's visibility to identify signs of pipe failure (leaks) along the landward slope. Recommend removing vegetation along pipe alignment to conduct proper inspection of structure. Sediment buildup in pipe visible from landward side--recommend contacting owner to clear pipe. (W. Wylie - DWR UCIP) FIELD_STRUCT_DESC: 24-inch corrugated metal gravity drainage pipe (CMP) through the levee, 10.2 feet below the crown. Flap gate on the waterside (WS) end. Concrete headwall on the landside (LS) end. Concrete U-shaped headwall on the WS end. [Additional Reference(s): DWR Levee Log, 2002, (HLM 22.18). USACE San Joaquin O&M Manual, Unit No. 601, Part No. 1, 1967, Amended in 1978, Revised 20 June 1985, (HLM 22.19). DWR As-Built Specification No. 64-01, Sheet No. 5, 6 November 1963, (HLM 22.19)]. FS Date: 6/23/2021

LS view: Closeup of inlet covered by vegetation at toe.

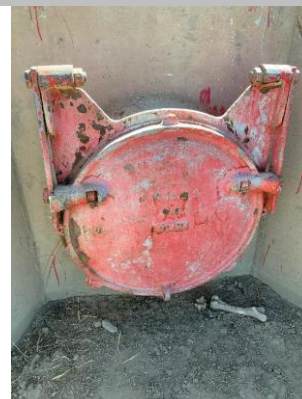
Photo 2 of 2 : UCIP_FA_2022_71049_104215.jpg

WS view: Closeup of flapgate at toe.

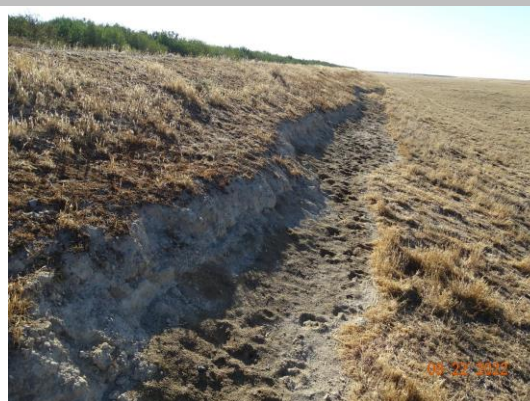
Photo 1 of 1 : FA_2022_NA0010_123_121_20221010_00373.jpg

LM Start	22.28	Rating **	M	Issue No.	121
LM End	22.35	Issue Type +	Ma	Location *	WS
Category	Earthen Levee			GPS Latitude/Longitude	
				Start	End
Item	Erosion / Livestock			37.083388 °	37.082696 °
				-120.528382 °	-120.527620 °
DWR ID	DWR_NA0010_05_f _ 2017_121				
Comment Code					
E4 : Repair the levee slope damaged by livestock and prevent large animal access.					
Inspector Comment					
Waterside slope damaged by animal traffic.

Looking southeast at the waterside slope. (Fall 2022)

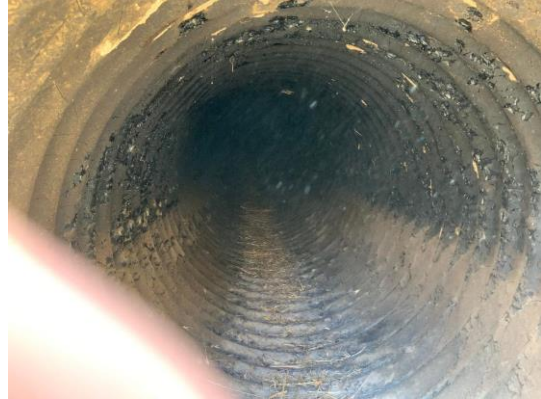
Photo 1 of 3 : UCIP_FA_2022_71050_104218.jpg

Comment Code					
Inspector Comment					
DS_ID:19790 FS_ID:71050 EP_NO: N/A Repair Type: Urgent EVAL Issue: 1, Pipe Integrity Crossing Status: Found UCIP Comments: 06/23/2021 The record has been upgraded from Non-Urgent to Urgent. DWR DMP internal inspection has found pipe integrity issues. LOF of crossing is greater than or equal to 5 and less than 6. Crossing will be monitored until funding becomes available to address the issues. Possible hole in WS flapgate. No permit was found authorizing this encroachment. CVFPB will need to review crossing to determine owner. The UCIP inspection was completed with GEI staff, P. Espinoza. (H. Dunn – GEI)04/23/2014 Dense vegetation limits the inspector's visibility to identify signs of pipe failure (leaks) along the landward slope. Recommend removing vegetation along pipe alignment to conduct proper inspection of structure. Sediment buildup in pipe visible from landward side--recommend contacting owner to clear pipe. (W. Wylie - DWR UCIP) FIELD_STRUCT_DESC: 24-inch corrugated metal gravity drainage pipe (CMP) through the levee, 10.4 feet below the crown. Flap gate on the waterside (WS) end. Concrete headwall on the landside (LS) end. Concrete U-shaped headwall on the WS end. [Additional Reference(s): DWR Levee Log, 2002, (HLM 22.46). USACE San Joaquin O&M Manual, Unit No. 601, Part No. 1, 1967, Amended in 1978, Revised 20 June 1985, (HLM 22.46). DWR As-Built Specification No. 64-01, Sheet No. 6, 6 November 1963, (HLM 22.46)]. FS Date: 6/23/2021

LS view: Inside pipe inlet at toe.

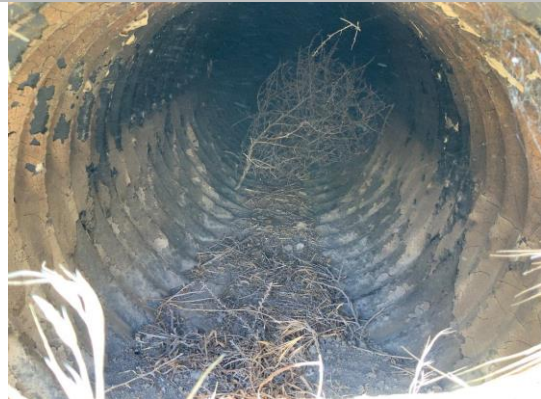
Photo 1 of 3 : UCIP_FA_2022_71051_104228.jpg

Comment Code						
Inspector Comment						
DS_ID:19791 FS_ID:71051 EP_NO: N/A Repair Type: Urgent EVAL Issue: 1, Pipe Integrity Crossing Status: Found UCIP Comments: 06/23/2021 The record has been upgraded from Non-Urgent to Urgent. DWR DMP internal inspection has found pipe integrity issues. LOF of crossing is greater than or equal to 5 and less than 6. Crossing will be monitored until funding becomes available to address the issues. Deterioration of the underside of the WS flapgate. No permit was found authorizing this encroachment. CVFPB will need to review crossing to determine owner. The UCIP inspection was completed with GEI staff, P. Espinoza. (H. Dunn – GEI)04/23/2014 Dense vegetation limits the inspector's visibility to identify signs of pipe failure (leaks) along the landward slope. Recommend removing vegetation along pipe alignment to conduct proper inspection of structure. Sediment buildup in pipe visible from landward side--recommend contacting owner to clear pipe. (W. Wylie - DWR UCIP) FIELD_STRUCT_DESC: 24-inch corrugated metal gravity drainage pipe (CMP) through the levee, 12.2 feet below the crown. Flap gate on the waterside (WS) end. Concrete headwall on the landside (LS) end. Concrete U-shaped headwall on the WS end. [Additional Reference(s): DWR Levee Log, 2002, (HLM 22.79). USACE San Joaquin O&M Manual, Unit No. 601, Part No. 1, 1967, Amended in 1978, Revised 20 June 1985, (HLM 22.79). DWR As-Built Specification No. 64-01, Sheet No. 6, 6 November 1963, (HLM 22.79)]. FS Date: 6/23/2021

LS view: Inside pipe inlet at toe.

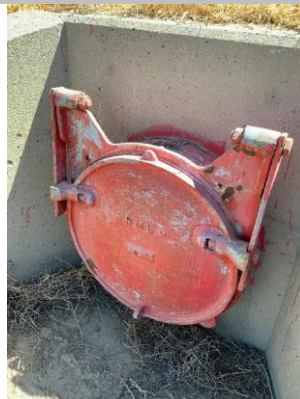
Photo 2 of 3 : UCIP_FA_2022_71051_104224.jpg

WS view: Closeup of flapgate at toe.

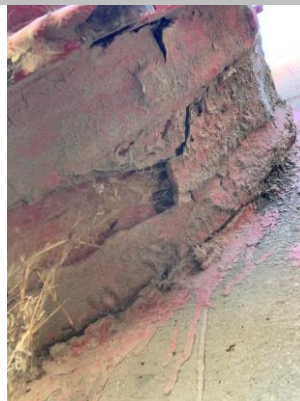
Photo 3 of 3 : UCIP_FA_2022_71051_104225.jpg

WS view: Deterioration and holes underneath flapgate at toe.

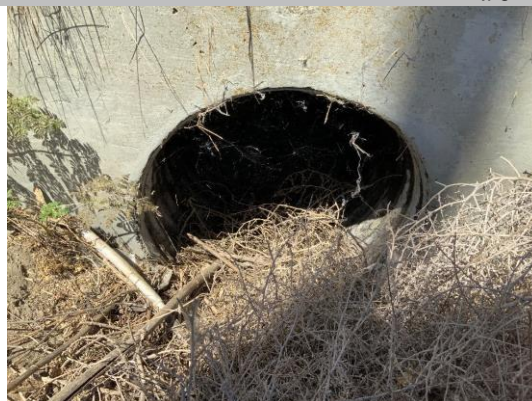
Photo 2 of 2 : UCIP_FA_2022_71053_104334.jpg

LS view: Closeup of inlet at toe.

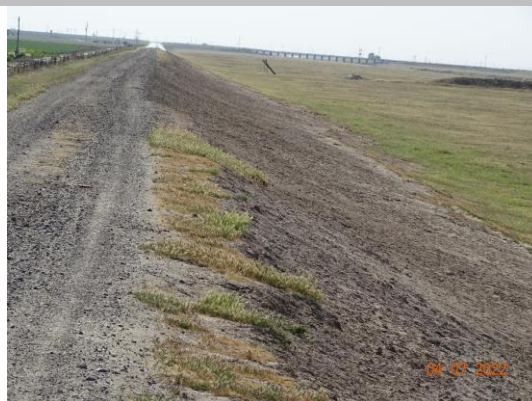
Photo 1 of 1 : FA_2022_NA0010_123_160_20220822_00049.jpg

LM Start	23.24	Rating **	M	Issue No.	160
LM End	23.68	Issue Type +	Ma	Location *	WS
Category	Earthen Levee			GPS Latitude/Longitude	
				Start	End
Item	Erosion / Livestock			37.073064 °	37.068260 °
				-120.516771 °	-120.511583 °
DWR ID	DWR_NA0010_05_f _ 2018_160				
Comment Code					
E4 : Repair the levee slope damaged by livestock and prevent large animal access.					
Inspector Comment					
There is slope damage caused by livestock on waterside.

Slope damage cause by livestock foot traffic. (Spring 2022)

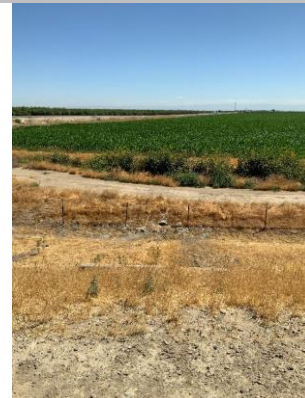
Photo 2 of 3 : UCIP_FA_2022_71054_104343.jpg

LS view: Toe from crown.

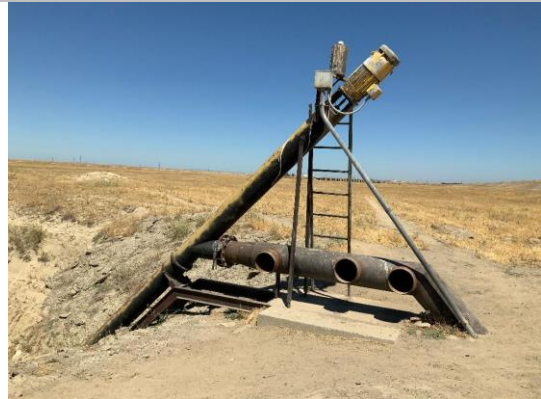
Photo 2 of 2 : UCIP_FA_2022_71055_104366.jpg

DS_ID:19795
 FS_ID:71055
 EP_NO: 13829
 Repair Type: Urgent
 EVAL Issue: 3a, Flood Risk
 Crossing Status: Found
 UCIP Comments: 06/23/2021 The record has been upgraded from No Action Needed to Urgent. Appears abandoned, WS pipe is missing parts as there are open holes without flapgates that would potentially allow water through, see photos. Open on both ends. Confirm with owner on the status of this pipe. The UCIP inspection was completed with GEI staff, P. Espinoza. (H. Dunn – GEI)
 FIELD_STRUCT_DESC: 1 of 2: 16-inch coated steel irrigation discharge pipe through the levee, 4.0 feet below the crown. Steel cutoff wall around the pipe at the center of the levee. Slant pump off the waterside (WS) toe. Siphon breaker in a 10-inch steel pipe riser unit on the landside (LS) shoulder. A preexisting ditch runs from the WS toe to the channel. Rock revetment on the cut slopes of the inlet channel. (Pump and 16-inch pipe authorized under Permit No. 13829, 1984 - John H. Sorenson, Inc.). [Additional Reference(s): DWR Levee Log, 2002, (HLM 23.51)].

WS view: Pump and pipe off the toe, 2 of 2 photos.

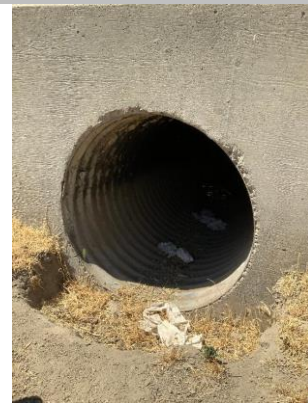
Photo 1 of 2 : UCIP_FA_2022_71057_104378.jpg

DS_ID:19796
 FS_ID:71057
 EP_NO: N/A
 Repair Type: Urgent
 EVAL Issue: 1, Pipe Integrity
 Crossing Status: Found
 UCIP Comments: 06/23/2021 The record has been upgraded from Non-Urgent to Urgent. DWR DMP internal inspection has found pipe integrity issues. LOF of crossing is greater than or equal to 5 and less than 6. Crossing will be monitored until funding becomes available to address the issues. No permit was found authorizing this encroachment. CVFPB will need to review crossing to determine owner. The UCIP inspection was completed with GEI staff, P. Espinoza. (H. Dunn – GEI)03/25/2014 Sediment buildup in pipe visible from landward side-- recommend contacting owner to clear pipe. (W. Wylie - DWR UCIP) FIELD_STRUCT_DESC: 30-inch corrugated metal gravity drainage pipe (CMP) through the levee, 12.1 feet below the crown. Flap gate on the waterside (WS) end. Concrete U-shaped headwall on the WS end. [Additional Reference(s): DWR Levee Log, 2002, (HLM 23.61). USACE San Joaquin O&M Manual, Unit No. 601, Part No. 1, 1967, Amended in 1978, Revised 20 June 1985, (HLM 23.62). DWR As-Built Specification No. 64-01, Sheet No. 7, 6 November 1963, (HLM 23.62)].

LS view: Closeup of pipe inlet at toe.

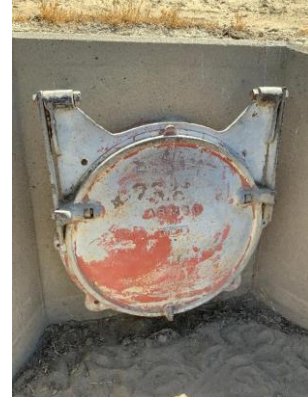
Photo 2 of 2 : UCIP_FA_2022_71057_104383.jpg

WS view: Closeup of flapgate at toe.

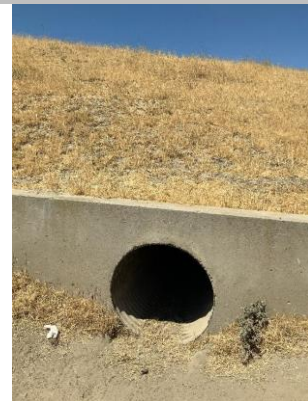
Photo 1 of 3 : UCIP_FA_2022_71058_104384.jpg

DS_ID:19797
 FS_ID:71058
 EP_NO: N/A
 Repair Type: Urgent
 EVAL Issue: 1, Pipe Integrity
 Crossing Status: Found
 UCIP Comments: 06/23/2021 The record has been upgraded from Non-Urgent to Urgent. DWR DMP internal inspection has found pipe integrity issues. LOF of crossing is greater than or equal to 5 and less than 6. Crossing will be monitored until funding becomes available to address the issues. Small hole seen in the front of the WS flapgate. No permit was found authorizing this encroachment. CVFPB will need to review crossing to determine owner. The UCIP inspection was completed with GEI staff, P. Espinoza. (H. Dunn – GEI)03/25/2014 Minor sediment/debris buildup in pipe visible from landward side--recommend contacting owner to clear pipe. (W. Wylie - DWR UCIP)
 FIELD_STRUCT_DESC: 36-inch corrugated metal gravity drainage pipe (CMP) through the levee, 12.1 feet below the crown. Flap gate on the waterside (WS) end. Concrete headwall on the landside (LS) end. Concrete U-shaped headwall on the WS end. [Additional Reference(s): DWR Levee Log, 2002, (HLM 23.92). USACE San Joaquin O&M Manual, Unit No. 601, Part No. 1, 1967, Amended in 1978, Revised 20 June 1985, (HLM 23.85). DWR As-Built Specification No. 64-01, Sheet No. 7, 6 November 1963, (HLM 23.85)].

LS view: Slope and headwall from toe.

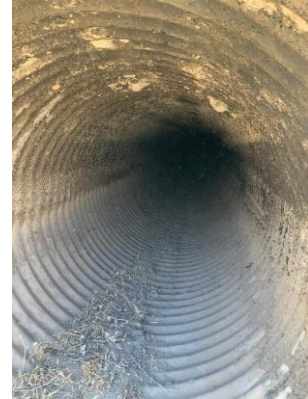
Photo 2 of 3 : UCIP_FA_2022_71058_104385.jpg

LS view: Closeup of inside inlet at toe.

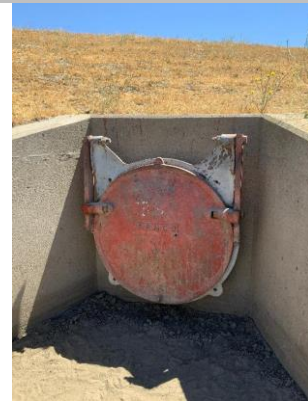
Photo 3 of 3 : UCIP_FA_2022_71058_104390.jpg

WS view: Closeup of flapgate at toe.

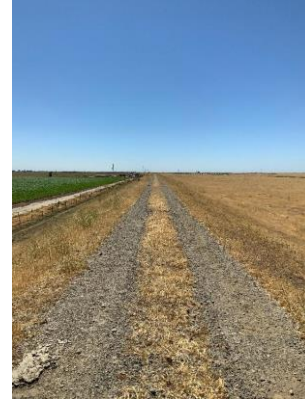
Photo 1 of 3 : UCIP_FA_2022_71059_104393.jpg

Levee crown.

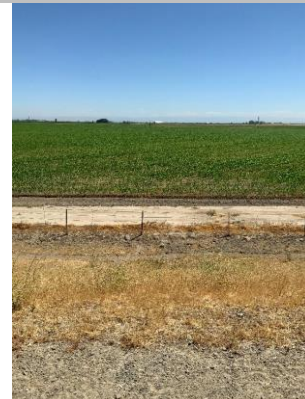
Photo 2 of 3 : UCIP_FA_2022_71059_104395.jpg

LS view: Toe from crown.

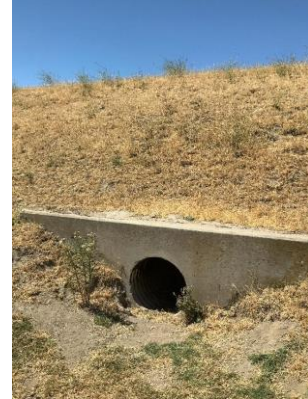
Photo 3 of 3 : UCIP_FA_2022_71059_104391.jpg

LS view: Slope and headwall from toe.

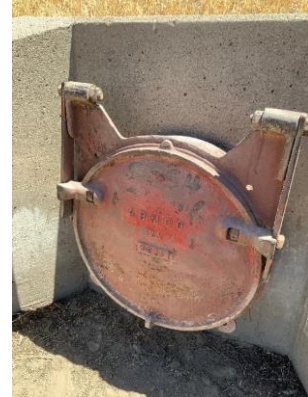
Photo 1 of 3 : UCIP_FA_2022_71060_104406.jpg

Comment Code						
Inspector Comment						
DS_ID:19799 FS_ID:71060 EP_NO: N/A Repair Type: Urgent EVAL Issue: 1, Pipe Integrity Crossing Status: Found UCIP Comments: 06/23/2021 The record has been upgraded from Non-Urgent to Urgent. DWR DMP internal inspection has found pipe integrity issues. LOF of crossing is greater than or equal to 5 and less than 6. Crossing will be monitored until funding becomes available to address the issues. Hole visible on underneath of flapgate on WS. No permit was found authorizing this encroachment. CVFPB will need to review crossing to determine owner. The UCIP inspection was completed with GEI staff, P. Espinoza. (H. Dunn – GEI)03/25/2014 Dense vegetation limits the inspector's visibility to identify signs of pipe failure (leaks) along the landward slope. Recommend removing vegetation along pipe alignment to conduct proper inspection of structure. (W. Wylie - DWR UCIP) FIELD_STRUCT_DESC: 24-inch corrugated metal gravity drainage pipe (CMP) through the levee, 11.2 feet below the crown. Flap gate on the waterside (WS) end. Concrete headwall on the landside (LS) end. Concrete U-shaped headwall on the WS end. [Additional Reference(s): DWR Levee Log, 2002, (HLM 24.46). USACE San Joaquin O&M Manual, Unit No. 601, Part No. 1, 1967, Amended in 1978, Revised 20 June 1985, (HLM 24.46). DWR As-Built Specification No. 64-01, Sheet No. 7, 6 November 1963, (HLM 24.46)]. FS Date: 6/23/2021

WS view: Closeup of flapgate at toe.

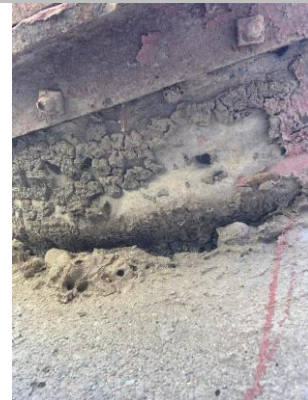
Photo 2 of 3 : UCIP_FA_2022_71060_104398.jpg

WS view: Closeup of hole under flapgate at toe, 1 of 2 photos.

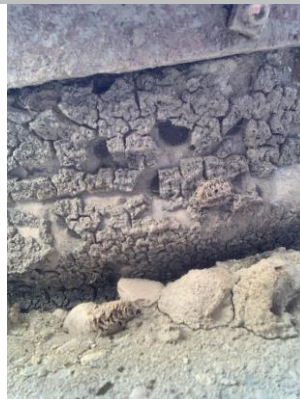
Photo 3 of 3 : UCIP_FA_2022_71060_104399.jpg

WS view: Closeup of hole under flapgate at toe, 2 of 2 photos.

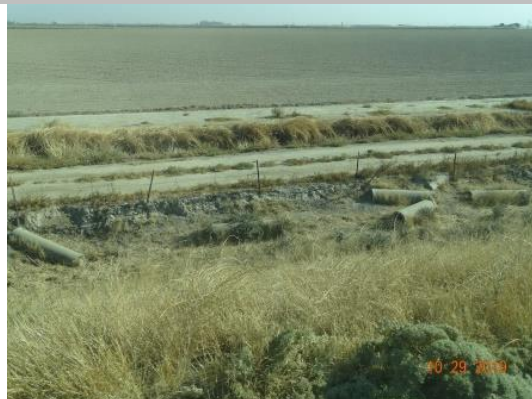
Photo 1 of 1 : FA_2022_NA0010_123_175_20220822_00060.jpg

LM Start	24.56	Rating **	M	Issue No.	175
LM End	24.56	Issue Type +	En	Location *	LS
Category	Earthen Levee			GPS Latitude/Longitude	
				Start	End
Item	Encroachments			37.058672 °	37.058672 °
				-120.501218 °	-120.501218 °
DWR ID	DWR_NA0010_05_f _ 2019_175				
Comment Code					
PI : Pipe					
Inspector Comment					
Concrete pipe left on landside toe.

Sections of concrete pipe left along the landside toe. (Fall 2019)

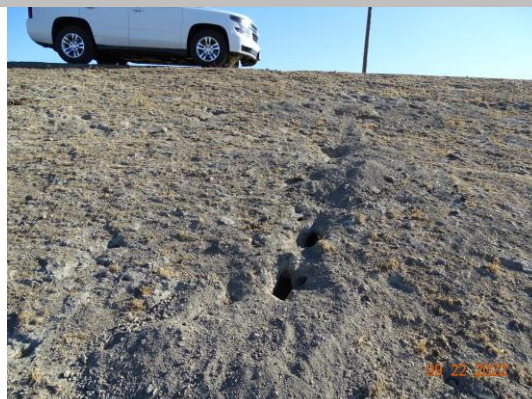
Photo 1 of 1 : FA_2022_NA0010_123_188_20221010_00374.jpg

LM Start	24.79	Rating **	M	Issue No.	188
LM End	24.79	Issue Type +	Ma	Location *	WS
Category	Earthen Levee			GPS Latitude/Longitude	
				Start	End
Item	Animal Control			37.056122 °	37.056122 °
				-120.498432 °	-120.498432 °
DWR ID	DWR_NA0010_05_f_2022_188				
Comment Code					
A3 : No rodents visible, but rodent burrows visible; need to backfill and compact or grout burrows.					
Inspector Comment

Several rodent burrows observed on the waterside slope. (Fall 2022)

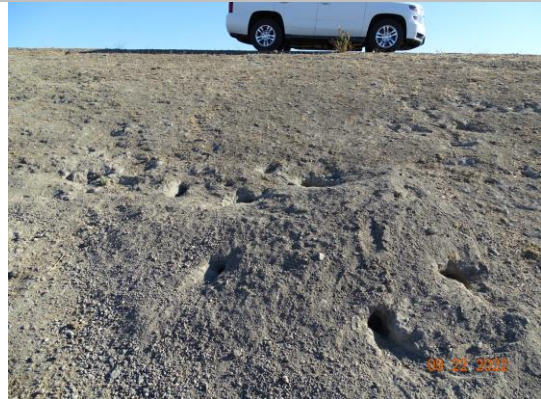
Photo 1 of 1 : FA_2022_NA0010_123_190_20221010_00375.jpg

LM Start	24.84	Rating **	M	Issue No.	190
LM End	24.84	Issue Type +	Ma	Location *	WS
Category	Earthen Levee			GPS Latitude/Longitude	
				Start	End
Item	Animal Control			37.055582 °	37.055582 °
				-120.497759 °	-120.497759 °
DWR ID	DWR_NA0010_05_f_2022_190				
Comment Code					
A3 : No rodents visible, but rodent burrows visible; need to backfill and compact or grout burrows.					
Inspector Comment

View of multiple rodent holes on the waterside slope. (Fall 2022)

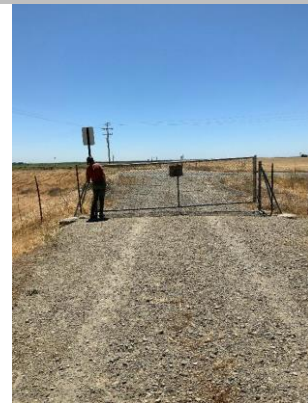
Photo 1 of 3 : UCIP_FA_2022_71061_104409.jpg

Levee crown.

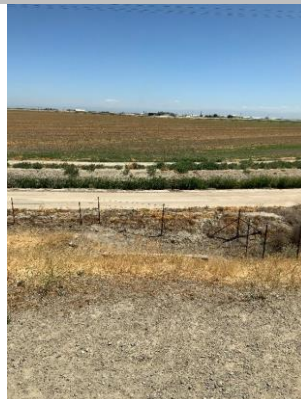
Photo 2 of 3 : UCIP_FA_2022_71061_104411.jpg

Comment Code					
Inspector Comment					
DS_ID:19800 FS_ID:71061 EP_NO: N/A Repair Type: Non-Urgent EVAL Issue: Crossing Status: Found UCIP Comments: 06/23/2021 The record has been upgraded from No Action Needed to Non-Urgent. DWR DMP internal inspection has not found pipe integrity issues. LOF of crossing is less or equal to 4.0. Recommend next video inspection in 5 years. No permit was found authorizing this encroachment. CVFPB will need to review crossing to determine owner. The UCIP inspection was completed with GEI staff, P. Espinoza. (H. Dunn – GEI) FIELD_STRUCT_DESC: 24-inch corrugated metal gravity drainage pipe (CMP) through the levee, 10.7 feet below the crown. Flap gate on the waterside (WS) end. Concrete headwall on the landside (LS) end. Concrete U-shaped headwall on the WS end. [Additional Reference(s): DWR Levee Log, 2002, (HLM 24.82). USACE San Joaquin O&M Manual, Unit No. 601, Part No. 1, 1967, Amended in 1978, Revised 20 June 1985, (HLM 24.82). DWR As-Built Specification No. 64-01, Sheet No. 7, 6 November 1963, (HLM 24.82)]. FS Date: 6/23/2021

LS view: Toe from crown.

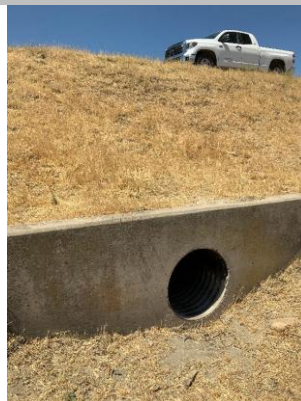
Photo 3 of 3 : UCIP_FA_2022_71061_104407.jpg

LS view: Slope and headwall from toe.

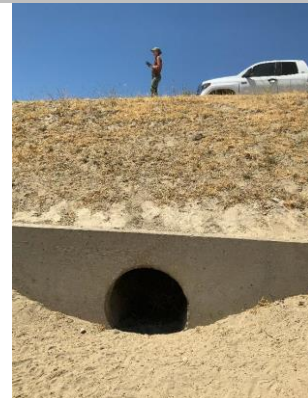
Photo 2 of 3 : UCIP_FA_2022_71062_104417.jpg

Comment Code						
Inspector Comment						
DS_ID:19801 FS_ID:71062 EP_NO: N/A Repair Type: Non-Urgent EVAL Issue: Crossing Status: Found UCIP Comments: 06/23/2021 The record has been upgraded from No Action Needed to Non-Urgent. DWR DMP internal inspection has not found pipe integrity issues. LOF of crossing is less or equal to 4.0. Recommend next video inspection in 5 years. No permit was found authorizing this encroachment. CVFPB will need to review crossing to determine owner. The UCIP inspection was completed with GEI staff, P. Espinoza. (H. Dunn – GEI) FIELD_STRUCT_DESC: 30-inch corrugated metal gravity drainage pipe (CMP) through the levee, 10.9 feet below the crown. Flap gate on the waterside (WS) end. Concrete headwall on the landside (LS) end. Concrete U-shaped headwall on the WS end. [Additional Reference(s): DWR Levee Log, 2002, (HLM 24.86). USACE San Joaquin O&M Manual, Unit No. 601, Part No. 1, 1967, Amended in 1978, Revised 20 June 1985, (HLM 24.87). DWR As-Built Specification No. 64-01, Sheet No. 7, 6 November 1963, (HLM 24.87)]. FS Date: 6/23/2021

LS view: Slope and headwall from toe.

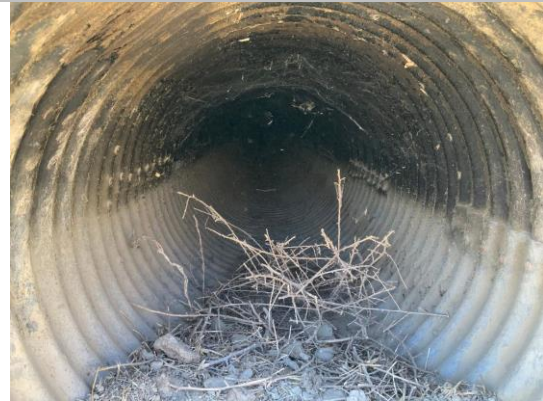
Photo 3 of 3 : UCIP_FA_2022_71062_104418.jpg

LS view: Inside pipe inlet at toe.

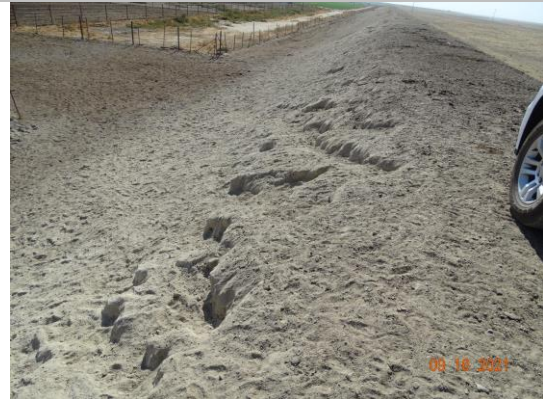
Photo 1 of 1 : FA_2022_NA0010_123_166_20220822_00053.jpg

LM Start	25.01	Rating **	M	Issue No.	166
LM End	25.04	Issue Type +	Ma	Location *	LS
Category	Earthen Levee			GPS Latitude/Longitude	
				Start	End
Item	Erosion / Livestock			37.053876 °	37.053538 °
				-120.495648 °	-120.495228 °
DWR ID	DWR_NA0010_05_f _ 2021_166				
Comment Code					
E4 : Repair the levee slope damaged by livestock and prevent large animal access.					
Inspector Comment

View of slope damage on the landside slope. (Fall 2021)

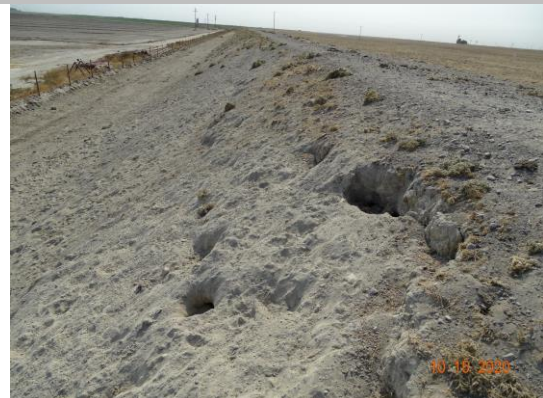
Photo 1 of 1 : FA_2022_NA0010_123_123_20220822_00023.jpg

LM Start	25.09	Rating **	M	Issue No.	123
LM End	25.09	Issue Type +	Ma	Location *	LS
Category	Earthen Levee			GPS Latitude/Longitude	
				Start	End
Item	Animal Control			37.053103 °	37.053103 °
				-120.494651 °	-120.494651 °
DWR ID	DWR_NA0010_05_f_2017_123				
Comment Code					
A1 : Exterminate rodents and backfill and compact or grout burrows.					
Inspector Comment

View of the landside slope looking upstream. (Fall 2020)

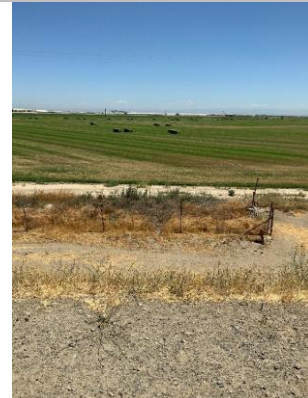
Photo 2 of 3 : UCIP_FA_2022_71064_104426.jpg

Comment Code					
Inspector Comment					
DS_ID:19803 FS_ID:71064 EP_NO: N/A Repair Type: Non-Urgent EVAL Issue: Crossing Status: Found UCIP Comments: 06/23/2021 The record remains Non-Urgent. DWR DMP internal inspection has not found pipe integrity issues. LOF of crossing is less or equal to 4.0. Recommend next video inspection in 5 years. No permit was found authorizing this encroachment. CVFPB will need to review crossing to determine owner. The UCIP inspection was completed with GEI staff, P. Espinoza. (H. Dunn – GEI) 03/25/2014 Flapgate propped open during flood season. (W. Wylie - DWR UCIP) FIELD_STRUCT_DESC: 30-inch corrugated metal gravity drainage pipe (CMP) through the levee, 11.3 feet below the crown. Flap gate on the waterside (WS) end. Concrete headwall on the landside (LS) end. Concrete U-shaped headwall on the WS end. [Additional Reference(s): DWR Levee Log, 2002, (HLM 25.14). USACE San Joaquin O&M Manual, Unit No. 601, Part No. 1, 1967, Amended in 1978, Revised 20 June 1985, (recorded incorrectly as HLM 25.43, should be 25.13). DWR As-Built Specification No. 64-01, Sheet No. 8, 6 November 1963, (HLM 25.13)]. FS Date: 6/23/2021

LS view: Toe from crown.

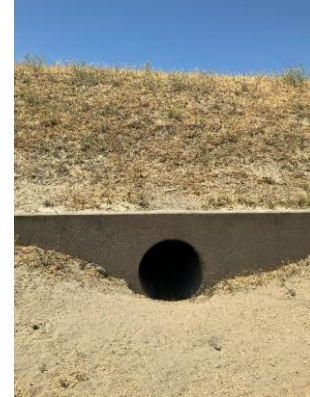
Photo 3 of 3 : UCIP_FA_2022_71064_104422.jpg

LS view: Slope and headwall from toe.

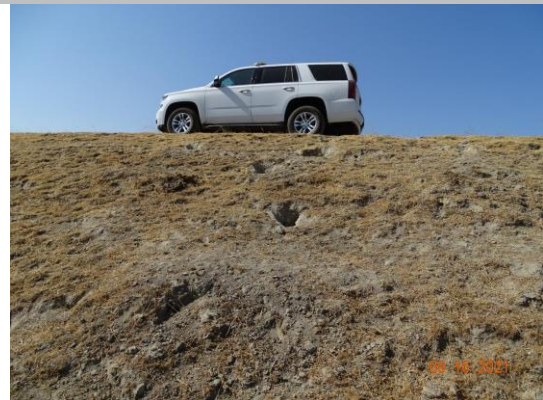
Photo 1 of 1 : FA_2022_NA0010_123_167_20220822_00054.jpg

LM Start	25.46	Rating **	M	Issue No.	167
LM End	25.52	Issue Type +	Ma	Location *	LS
Category	Earthen Levee			GPS Latitude/Longitude	
				Start	End
Item	Animal Control			37.049218 °	37.048502 °
				-120.489883 °	-120.489257 °
DWR ID	DWR_NA0010_05_f_2021_167				
Comment Code					
A3 : No rodents visible, but rodent burrows visible; need to backfill and compact or grout burrows.					
Inspector Comment

Multiple rodent holes observed on the landside slope. (Fall 2021)

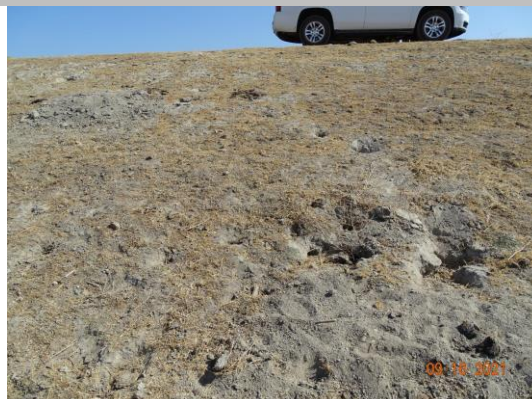
Photo 1 of 1 : FA_2022_NA0010_123_168_20220822_00055.jpg

LM Start	25.46	Rating **	M	Issue No.	168
LM End	25.46	Issue Type +	Ma	Location *	WS
Category	Earthen Levee			GPS Latitude/Longitude	
				Start	End
Item	Animal Control			37.049217 °	37.049217 °
				-120.489881 °	-120.489881 °
DWR ID	DWR_NA0010_05_f_2021_168				
Comment Code					
A3 : No rodents visible, but rodent burrows visible; need to backfill and compact or grout burrows.					
Inspector Comment

View of rodent burrows on the waterside slope. (Fall 2021)

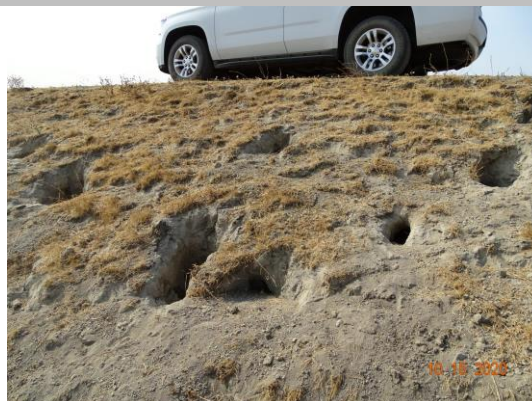
Photo 1 of 1 : FA_2022_NA0010_123_148_20220822_00041.jpg

LM Start	25.58	Rating **	U	Issue No.	148
LM End	25.60	Issue Type +	Ma	Location *	LS
Category	Earthen Levee			GPS Latitude/Longitude	
				Start	End
Item	Animal Control			37.047827 °	37.047551 °
				-120.488738 °	-120.488527 °
DWR ID	DWR_NA0010_05_f_2020_148				
Comment Code					
A3 : No rodents visible, but rodent burrows visible; need to backfill and compact or grout burrows.					
Inspector Comment

View of burrows in the landside. (Fall 2020)

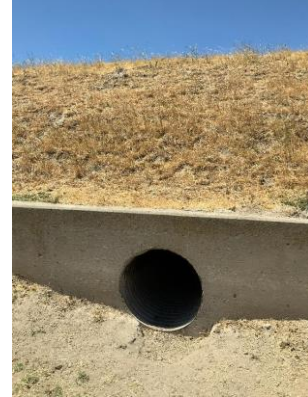
Photo 1 of 3 : UCIP_FA_2022_71065_104429.jpg

Comment Code					
Inspector Comment					
DS_ID:19804 FS_ID:71065 EP_NO: N/A Repair Type: Urgent EVAL Issue: 1, Pipe Integrity Crossing Status: Found UCIP Comments: 06/23/2021 The record has been upgraded from Non-Urgent to Urgent. DWR DMP internal inspection has found pipe integrity issues. LOF of crossing is greater than or equal to 5 and less than 6. Crossing will be monitored until funding becomes available to address the issues. No permit was found authorizing this encroachment. CVFPB will need to review crossing to determine owner. The UCIP inspection was completed with GEI staff, P. Espinoza. (H. Dunn – GEI)03/25/2014 Dense vegetation limits the inspector's visibility to identify signs of pipe failure (leaks) along the landward slope. Recommend removing vegetation along pipe alignment to conduct proper inspection of structure. Sediment buildup in pipe visible from landward side--recommend contacting owner to clear pipe. (W. Wylie - DWR UCIP) FIELD_STRUCT_DESC: 30-inch corrugated metal gravity drainage pipe (CMP) through the levee, 12.0 feet below the crown. Flap gate on the waterside (WS) end. Concrete headwall on the landside (LS) end. Concrete U-shaped headwall on the WS end. [Additional Reference(s): DWR Levee Log, 2002, (HLM 25.51). USACE San Joaquin O&M Manual, Unit No. 601, Part No. 1, 1967, Amended in 1978, Revised 20 June 1985, (HLM 25.51). DWR As-Built Specification No. 64-01, Sheet No. 8, 6 November 1963, (HLM 25.51)]. FS Date: 6/23/2021

LS view: Slope and headwall from toe.

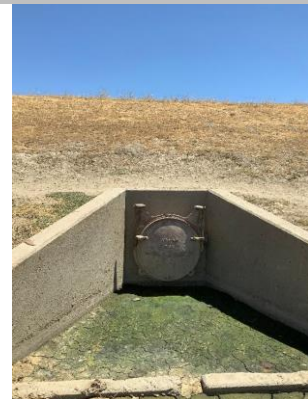
Photo 2 of 2 : UCIP_FA_2022_71066_104439.jpg

Comment Code					
Inspector Comment					
DS_ID:19805 FS_ID:71066 EP_NO: N/A Repair Type: Urgent EVAL Issue: 1, Pipe Integrity Crossing Status: Found UCIP Comments: 06/23/2021 The record has been upgraded from Non-Urgent to Urgent. DWR DMP internal inspection has found pipe integrity issues. LOF of crossing is greater than or equal to 5 and less than 6. Crossing will be monitored until funding becomes available to address the issues. No permit was found authorizing this encroachment. CVFPB will need to review crossing to determine owner. The UCIP inspection was completed with GEI staff, P. Espinoza. (H. Dunn – GEI)03/25/2014 Sediment buildup in pipe visible from landward side-- recommend contacting owner to clear pipe. (W. Wylie - DWR UCIP) FIELD_STRUCT_DESC: 30-inch corrugated metal gravity drainage pipe (CMP) through the levee, 12.1 feet below the crown. Flap gate on the waterside (WS) end. Concrete headwall on the landside (LS) end. Concrete U-shaped headwall on the WS end. [Additional Reference(s): DWR Levee Log, 2002, (HLM 25.53). USACE San Joaquin O&M Manual, Unit No. 601, Part No. 1, 1967, Amended in 1978, Revised 20 June 1985, (HLM 25.53). DWR As-Built Specification No. 64-01, Sheet No. 8, 6 November 1963, (HLM 25.53)]. FS Date: 6/23/2021

WS view: Slope, headwall, and flapgate from toe.

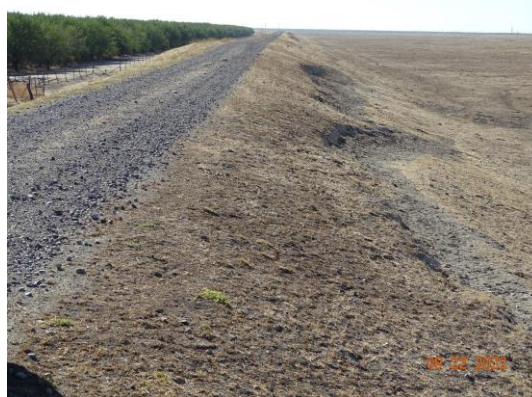
Photo 1 of 1 : FA_2022_NA0010_123_161_20221010_00376.jpg

LM Start	26.17	Rating **	M	Issue No.	161
LM End	26.21	Issue Type +	Ma	Location *	WS
Category	Earthen Levee			GPS Latitude/Longitude	
				Start	End
Item	Erosion / Livestock			37.040434 °	37.040043 °
				-120.483086 °	-120.482795 °
DWR ID	DWR_NA0010_05_f _ 2018_161				
Comment Code					
E4 : Repair the levee slope damaged by livestock and prevent large animal access.					
Inspector Comment					
Waterside slope damage is caused by livestock foot traffic.

Slope damage on waterside. (Fall 2022)

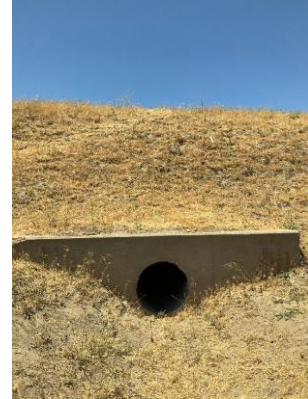
Photo 1 of 3 : UCIP_FA_2022_71067_104448.jpg

Comment Code					
Inspector Comment					
DS_ID:19806 FS_ID:71067 EP_NO: N/A Repair Type: Urgent EVAL Issue: 1, Pipe Integrity Crossing Status: Found UCIP Comments: 06/23/2021 The record has been upgraded from Non-Urgent to Urgent. DWR DMP internal inspection has found pipe integrity issues. LOF of crossing is greater than or equal to 5 and less than 6. Crossing will be monitored until funding becomes available to address the issues. No permit was found authorizing this encroachment. CVFPB will need to review crossing to determine owner. The UCIP inspection was completed with GEI staff, P. Espinoza. (H. Dunn – GEI)03/25/2014 Sediment buildup in pipe visible from landward side--recommend contacting owner to clear pipe. (W. Wylie - DWR UCIP) FIELD_STRUCT_DESC: 24-inch corrugated metal gravity drainage pipe (CMP) through the levee, 10.0 feet below the crown. Flap gate on the waterside (WS) end. Concrete headwall on the landside (LS) end. Concrete U-shaped headwall on the WS end. [Additional Reference(s): DWR Levee Log, 2002, (HLM 26.10). USACE San Joaquin O&M Manual, Unit No. 601, Part No. 1, 1967, Amended in 1978, Revised 20 June 1985, (HLM 26.11). DWR As-Built Specification No. 64-01, Sheet No. 8, 6 November 1963, (HLM 26.11)]. FS Date: 6/23/2021

LS view: Slope and headwall from toe.

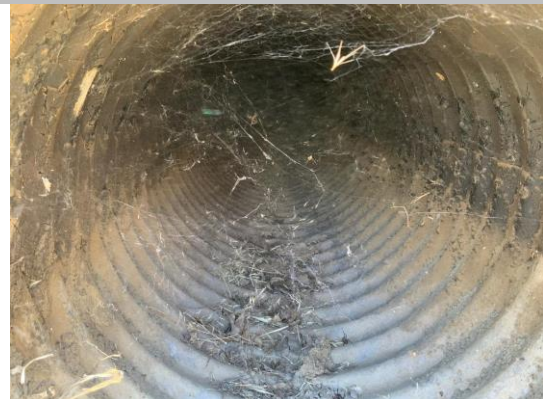
Photo 2 of 3 : UCIP_FA_2022_71067_104449.jpg

LS view: Inside pipe inlet at toe.

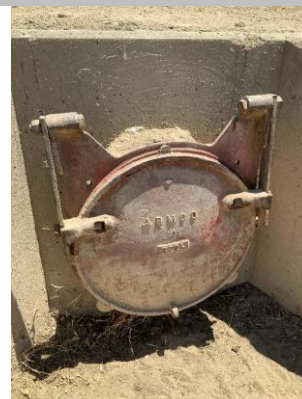
Photo 3 of 3 : UCIP_FA_2022_71067_104454.jpg

WS view: Closeup of flapgate at toe.

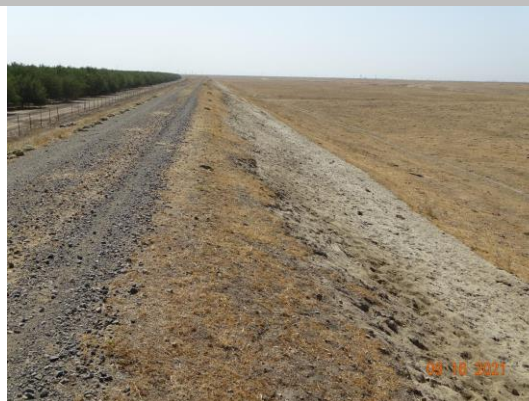
Photo 1 of 1 : FA_2022_NA0010_123_169_20220822_00056.jpg

LM Start	26.30	Rating **	M	Issue No.	169
LM End	26.69	Issue Type +	Ma	Location *	WS
Category	Earthen Levee			GPS Latitude/Longitude	
				Start	End
Item	Erosion / Livestock			37.038855 °	37.034140 °
				-120.481877 °	-120.478076 °
DWR ID	DWR_NA0010_05_f_2021_169				
Comment Code					
E4 : Repair the levee slope damaged by livestock and prevent large animal access.					
Inspector Comment					
Damage to the waterside slope from cattle traffic and minor damage on the landside slope.

View of slope damage from cattle traffic. (Fall 2021)

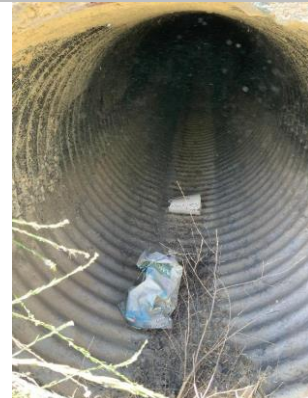
Photo 2 of 3 : UCIP_FA_2022_71068_104460.jpg

Comment Code						
Inspector Comment						
DS_ID:19807 FS_ID:71068 EP_NO: N/A Repair Type: Urgent EVAL Issue: 1, Pipe Integrity Crossing Status: Found UCIP Comments: 06/23/2021 The record has been upgraded from No Action Needed to Urgent. DWR DMP internal inspection has found pipe integrity issues. LOF of crossing is greater than or equal to 5 and less than 6. Crossing will be monitored until funding becomes available to address the issues. No permit was found authorizing this encroachment. CVFPB will need to review crossing to determine owner. The UCIP inspection was completed with GEI staff, P. Espinoza. (H. Dunn – GEI) FIELD_STRUCT_DESC: 36-inch corrugated metal gravity drainage pipe (CMP) through the levee, 13.0 feet below the crown. Flap gate on the waterside (WS) end. Concrete headwall on the landside (LS) end. Concrete U-shaped headwall on the WS end. [Additional Reference(s): DWR Levee Log, 2002, (HLM 26.29). USACE San Joaquin O&M Manual, Unit No. 601, Part No. 1, 1967, Amended in 1978, Revised 20 June 1985, (HLM 26.29). DWR As-Built Specification No. 64-01, Sheet No. 9, 6 November 1963, (HLM 26.29)]. FS Date: 6/23/2021

LS view: Inside of inlet at toe.

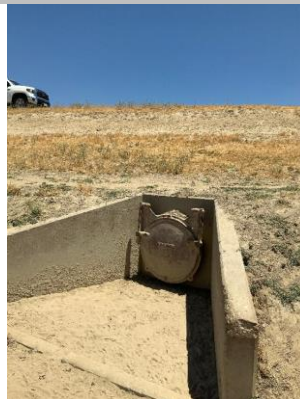
Photo 3 of 3 : UCIP_FA_2022_71068_104458.jpg

WS view: Slope, headwall, and flapgate from toe.

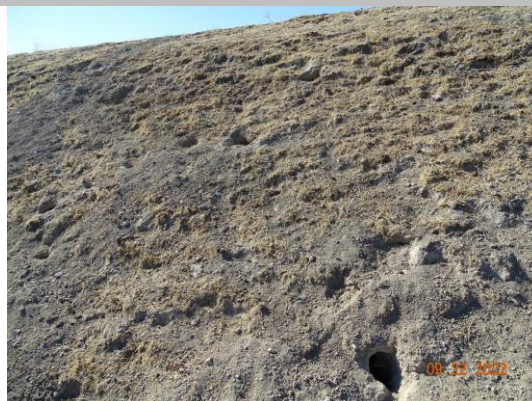
Photo 1 of 1 : FA_2022_NA0010_123_191_20221010_00377.jpg

LM Start	26.85	Rating **	M	Issue No.	191
LM End	26.92	Issue Type +	Ma	Location *	LS
Category	Earthen Levee			GPS Latitude/Longitude	
				Start	End
Item	Animal Control			37.032891 °	37.032685 °
				-120.475608 °	-120.474378 °
DWR ID	DWR_NA0010_05_f_2022_191				
Comment Code					
A3 : No rodents visible, but rodent burrows visible; need to backfill and compact or grout burrows.					
Inspector Comment

View of rodent burrows in the landside slope. (Fall 2022)

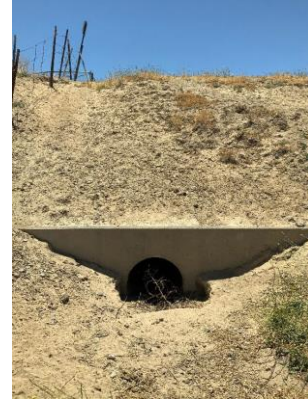
Photo 1 of 3 : UCIP_FA_2022_71069_104463.jpg

Comment Code					
Inspector Comment					
DS_ID:19808 FS_ID:71069 EP_NO: N/A Repair Type: Urgent EVAL Issue: 1, Pipe Integrity Crossing Status: Found UCIP Comments: 06/23/2021 The record has been upgraded from Non-Urgent to Urgent. LOF of crossing is greater than or equal to 5 and less than 6. Crossing will be monitored until funding becomes available to address issues. No permit was found authorizing this encroachment. CVFPB will need to review crossing to determine owner. The UCIP inspection was completed with GEI staff, P. Espinoza. (H. Dunn – GEI)03/25/2014 Pipe has heavy silt buildup visible from landward side--recommend contacting owner to clear pipe. (W. Wylie - DWR UCIP) FIELD_STRUCT_DESC: 24-inch corrugated metal gravity drainage pipe (CMP) through the levee, 11.4 feet below the crown. Flap gate on the waterside (WS) end. Concrete headwall on the landside (LS) end. Concrete U-shaped headwall on the WS end. [Additional Reference(s): DWR Levee Log, 2002, (HLM 26.85). USACE San Joaquin O&M Manual, Unit No. 601, Part No. 1, 1967, Amended in 1978, Revised 20 June 1985, (HLM 26.85). DWR As-Built Specification No. 64-01, Sheet No. 9, 6 November 1963, (HLM 26.85)]. FS Date: 6/23/2021

LS view: Slope and headwall from toe.

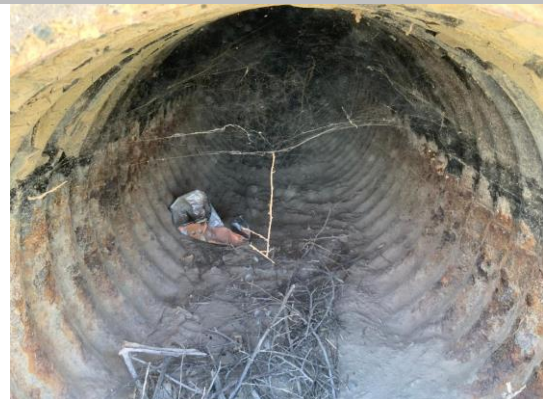
Photo 2 of 3 : UCIP_FA_2022_71069_104464.jpg

LS view: Inside of pipe inlet at toe.

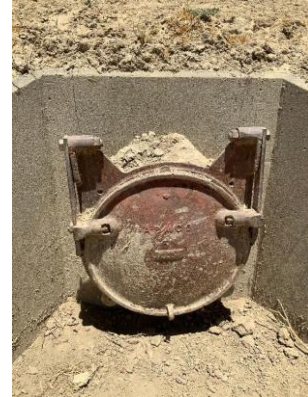
Photo 3 of 3 : UCIP_FA_2022_71069_104466.jpg

WS view: Closeup of flapgate at toe.

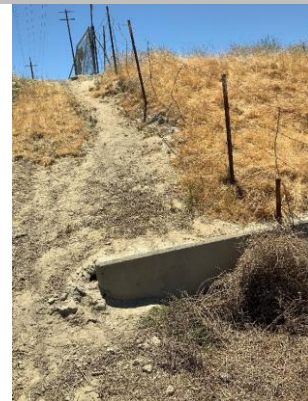
Photo 1 of 2 : UCIP_FA_2022_71071_104361.jpg

DS_ID:19748
 FS_ID:71071
 EP_NO: N/A
 Repair Type: Urgent
 EVAL Issue: 1, Pipe Integrity
 Crossing Status: Found
 UCIP Comments: 06/23/2021 Record has been upgraded from Non-Urgent to Urgent. DWR DMP internal inspection has found pipe integrity issues. LOF of crossing is greater than or equal to 5 and less than 6. Crossing will be monitored until funding becomes available to address the issues. Limited inspection of LS inlet due to dirt and tumbleweeds, recommend removal. Unidentified PVC pipe installed at mouth of inlet pipe on LS. No permit was found authorizing this encroachment. CVFPB will need to review crossing to determine owner. The UCIP inspection was completed with GEI staff, H.Dunn. (P.Espinoza – GEI)03/25/2014 Tumble weed buildup at inlet mat create blockage and should be removed. (W. Wylie - DWR UCIP)
 FIELD_STRUCT_DESC: 24-inch corrugated metal gravity drainage pipe (CMP) through the levee, 11.3 feet below the crown. Flap gate on the waterside (WS) end. Concrete headwall on the landside (LS) end. Concrete U-shaped headwall on the WS end. [Additional Reference(s): DWR Levee Log, 2002, (HLM 26.87). USACE San Joaquin O&M Manual, Unit No. 601, Part No. 1, 1967, Amended in 1978, Revised 20 June 1985, (HLM 26.87). DWR As-Built Specification No. 64-01, Sheet No. 9, 6 November 1963, (HLM 26.87)].

LS view from toe: concrete headwall at inlet

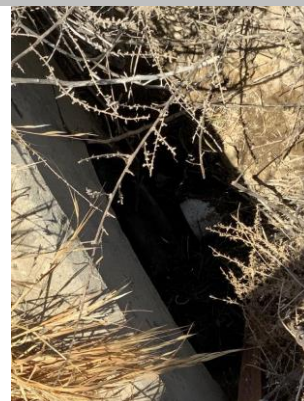
Photo 2 of 2 : UCIP_FA_2022_71071_104362.jpg

LS view from toe: close up of inlet. PVC pipe at entrance.

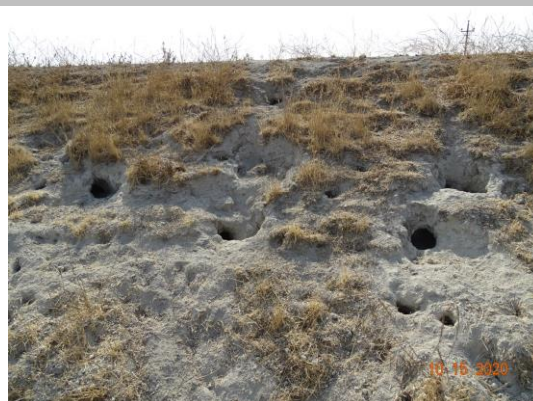
Photo 1 of 1 : FA_2022_NA0010_123_162_20220822_00051.jpg

LM Start	26.99	Rating **	U	Issue No.	162
LM End	27.04	Issue Type +	Ma	Location *	LS
Category	Earthen Levee			GPS Latitude/Longitude	
				Start	End
Item	Animal Control			37.032651 °	37.032659 °
				-120.473205 °	-120.472190 °
DWR ID	DWR_NA0010_05_f_2018_162				
Comment Code					
A1 : Exterminate rodents and backfill and compact or grout burrows.					
Inspector Comment					
Several rodent burrows with large quantities of material displaced noted in this section.

Several rodent burrows noted in this section of the levee. (Fall 2020)

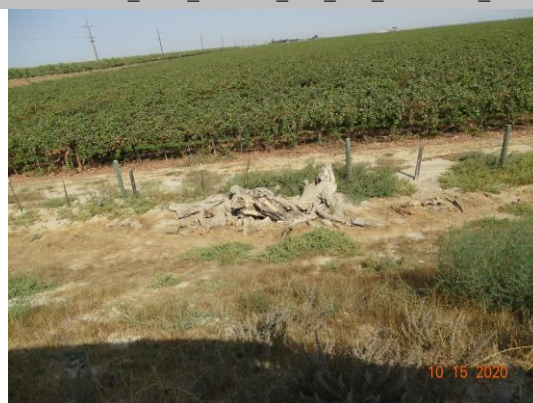
Photo 1 of 1 : FA_2022_NA0010_123_125_20220822_00025.jpg

LM Start	27.01	Rating **	M	Issue No.	125
LM End	27.01	Issue Type +	Ma	Location *	LS
Category	Earthen Levee			GPS Latitude/Longitude	
				Start	End
Item	Trim / Thin Trees			37.032675 °	37.032675 °
				-120.472841 °	-120.472841 °
DWR ID	DWR_NA0010_05_s_2021_125				
Comment Code					
T2 : Tree or limb.					
Inspector Comment

Prunings left on the landside toe. (Fall 2020)

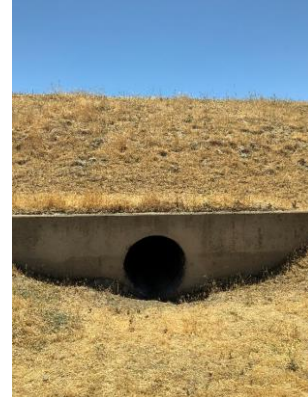
Photo 1 of 3 : UCIP_FA_2022_71072_104356.jpg

Comment Code					
Inspector Comment					
DS_ID:19749 FS_ID:71072 EP_NO: N/A Repair Type: Urgent EVAL Issue: 1, Pipe Integrity Crossing Status: Found UCIP Comments: 06/23/2021 The record has been upgraded from No Action Needed to Urgent. DWR DMP internal inspection has found pipe integrity issues. LOF of crossing is greater than or equal to 5 and less than 6. Crossing will be monitored until funding becomes available to address the issues. No permit was found authorizing this encroachment. CVFPB will need to review crossing to determine owner. The UCIP inspection was completed with GEI staff, H.Dunn. (P.Espinoza – GEI) FIELD_STRUCT_DESC: 36-inch corrugated metal gravity drainage pipe (CMP) through the levee, 12.0 feet below the crown. Flap gate on the waterside (WS) end. Concrete headwall on the landside (LS) end. Concrete U-shaped headwall on the WS end. [Additional Reference(s): DWR Levee Log, 2002, (HLM 27.21). USACE San Joaquin O&M Manual, Unit No. 601, Part No. 1, 1967, Amended in 1978, Revised 20 June 1985, (HLM 27.22). DWR As-Built Specification No. 64-01, Sheet No. 10, 6 November 1963, (HLM 27.22)]. FS Date: 6/23/2021

LS view from toe: concrete headwall at inlet.

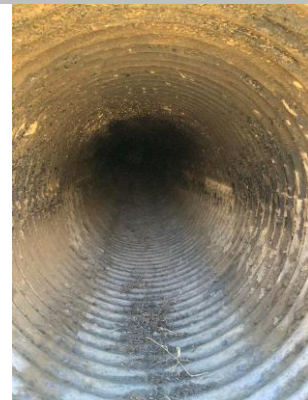
Photo 2 of 3 : UCIP_FA_2022_71072_104357.jpg

LS view from toe: inside of inlet.

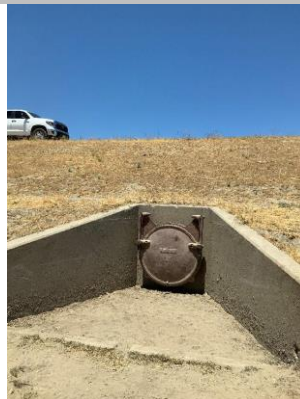
Photo 3 of 3 : UCIP_FA_2022_71072_104355.jpg

WS view from toe: flapgate on concrete headwall at outlet.

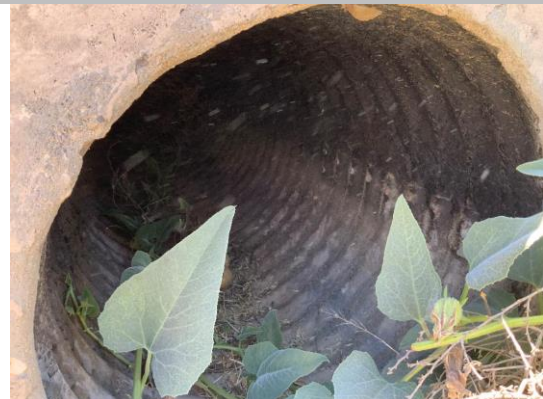
Photo 2 of 2 : UCIP_FA_2022_71073_104351.jpg

LS view from toe: inside of inlet pipe.

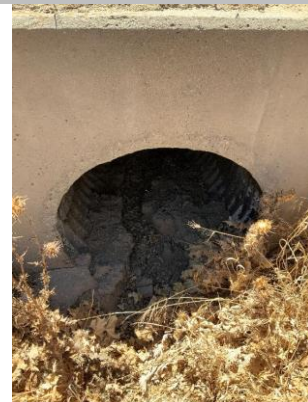
Photo 2 of 3 : UCIP_FA_2022_71074_104323.jpg

LS view from toe: closeup of entrance to pipe.

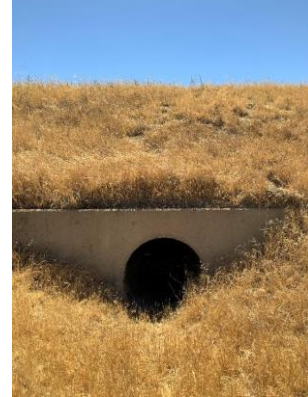
Photo 1 of 3 : UCIP_FA_2022_71076_104311.jpg

Comment Code						
Inspector Comment						
DS_ID:19753 FS_ID:71076 EP_NO: N/A Repair Type: Non-Urgent EVAL Issue: 5, Pipe Damage Crossing Status: Found UCIP Comments: 06/23/2021 The record remains Non-Urgent. DWR DMP internal inspection has found pipe integrity issues. LOF of crossing is between 4.1 and 5. Crossing will be monitored until funding becomes available for rehabilitation. No permit was found authorizing this encroachment. CVFPB will need to review crossing to determine owner. The UCIP inspection was completed with GEI staff, H.Dunn. (P.Espinoza – GEI) 03/27/2014 Dense vegetation limits the inspector's visibility to identify signs of pipe failure (leaks) along the landward slope. Recommend removing vegetation along pipe alignment to conduct proper inspection of structure. Sediment buildup in pipe visible from landward side--recommend contacting owner to clear pipe. (W. Wylie - DWR UCIP) FIELD_STRUCT_DESC: 36-inch corrugated metal gravity drainage pipe (CMP) through the levee, 10.2 feet below the crown. Flap gate on the waterside (WS) end. Concrete headwall on the landside (LS) end. Concrete U-shaped headwall on the WS end. [Additional Reference(s): DWR Levee Log, 2002, (HLM 29.49). USACE San Joaquin O&M Manual, Unit No. 601, Part No. 1, 1967, Amended in 1978, Revised 20 June 1985, (HLM 29.49). DWR As-Built Specification No. 64-01, Sheet No. 12, 6 November 1963, (HLM 29.49)]. FS Date: 6/23/2021

LS view from toe: concrete headwall at inlet.

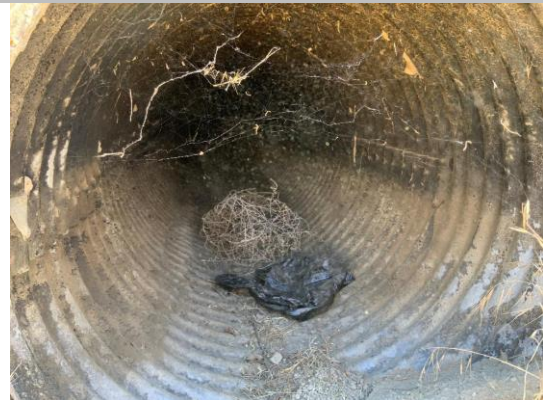
Photo 2 of 3 : UCIP_FA_2022_71076_104312.jpg

LS view from toe: inside of inlet pipe.
