Flood Control Project Maintenance Levee Inspections

Fall 2022 Levee Maintenance Deficiency Summary Report

San Joaquin River Basin

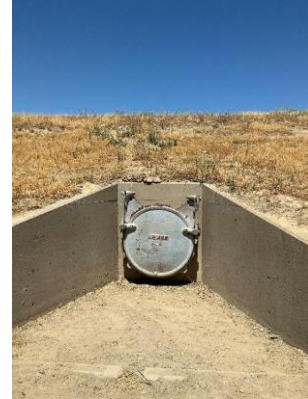
Photo 3 of 3 : UCIP_FA_2022_71076_104310.jpg

WS view from toe: flapgate on concrete headwall at outlet.

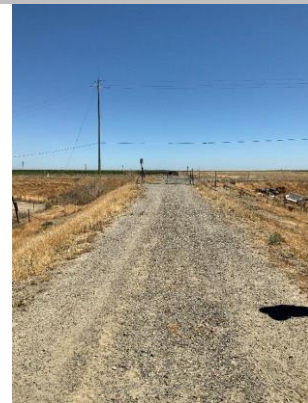
Photo 1 of 3 : UCIP_FA_2022_71087_104303.jpg

DS_ID:19754
 FS_ID:71087
 EP_NO: N/A
 Repair Type: Non-Urgent
 EVAL Issue:
 Crossing Status: Found
 UCIP Comments: 06/23/2021 The record remains Non-Urgent.
 Crossing appears to be in good condition. No permit was found authorizing this encroachment. CVFPB will need to review crossing to determine owner. The UCIP inspection was completed with GEI staff, H.Dunn. (P.Espinoza – GEI) 03/27/2014 Dense vegetation limits the inspector's visibility to identify signs of pipe failure (leaks) along the landward slope. Recommend removing vegetation along pipe alignment to conduct proper inspection of structure. (W. Wylie - DWR UCIP)
 FIELD_STRUCT_DESC: 30-inch by 30-inch reinforced concrete box gravity drainage culvert (RCBC) through the levee, 12.0 feet below the crown. Flap gate on the waterside (WS) end. Concrete headwall on the landside (LS) end. Concrete U-shaped headwall on the WS end.
 [Additional Reference(s): DWR Levee Log, 2002, (HLM 29.72). USACE San Joaquin O&M Manual, Unit No. 601, Part No. 1, 1967, Amended in 1978, Revised 20 June 1985, (HLM 29.72). DWR As-Built Specification No. 64-42, Sheet No. 6, 13 August 1964, (HLM 29.72)].

View from levee crown.

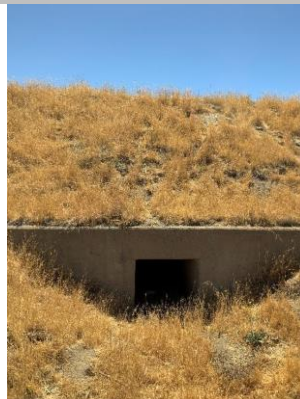
Photo 2 of 3 : UCIP_FA_2022_71087_104305.jpg

LS view from toe: concrete headwall at inlet.

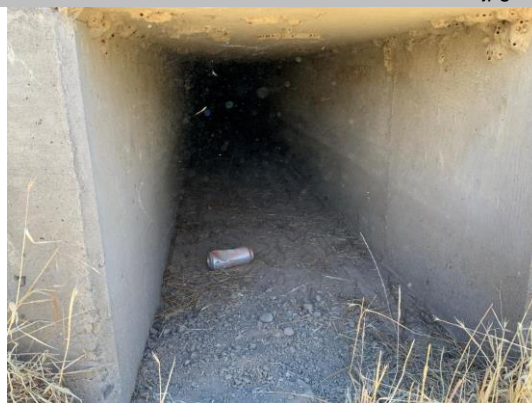
Photo 3 of 3 : UCIP_FA_2022_71087_104306.jpg

LS view from toe: inside of inlet.

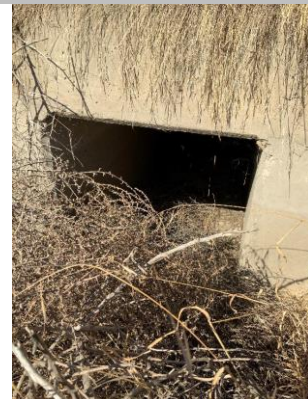
Photo 2 of 2 : UCIP_FA_2022_71078_104302.jpg

LS view from toe: closeup of inlet.

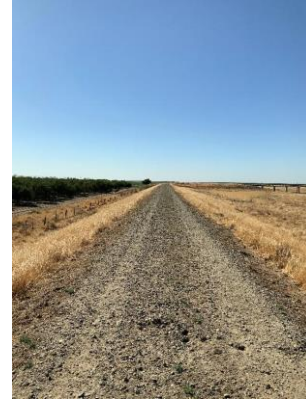
Photo 1 of 3 : UCIP_FA_2022_71079_104289.jpg

Comment Code						
Inspector Comment						
DS_ID:19697						
FS_ID:71079						
EP_NO: N/A						
Repair Type: Non-Urgent						
EVAL Issue:						
Crossing Status: Found						
UCIP Comments: 06/24/2021 The record remains Non-Urgent.						
Crossing appears to be in good condition. No permit was found authorizing this encroachment. CVFPB will need to review crossing to determine owner. The UCIP inspection was completed with GEI staff, H.Dunn. (P.Espinoza – GEI) 03/27/2014 Some debris buildup at LS toe. Dense vegetation limits the inspector's visibility to identify signs of pipe failure (leaks) along the landward slope. Recommend removing vegetation along pipe alignment to conduct proper inspection of structure. (W. Wylie - DWR UCIP)						
FIELD_STRUCT_DESC: 30-inch by 30-inch reinforced concrete box gravity drainage culvert (RCBC) through the levee, 13.3 feet below the crown. Flap gate on the waterside (WS) end. Concrete headwall on the landside (LS) end. Concrete U-shaped headwall on the WS end.

Levee crown.

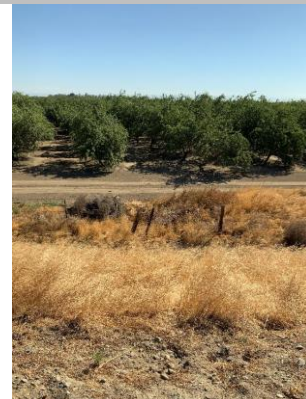
Photo 2 of 3 : UCIP_FA_2022_71079_104291.jpg

LS view from crown.

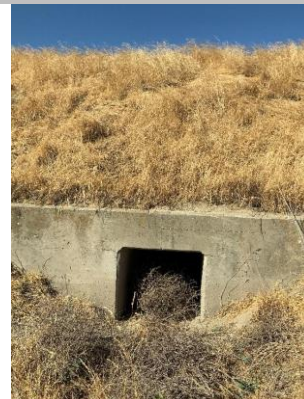
Photo 3 of 3 : UCIP_FA_2022_71079_104294.jpg

LS view from toe: concrete headwall at inlet.

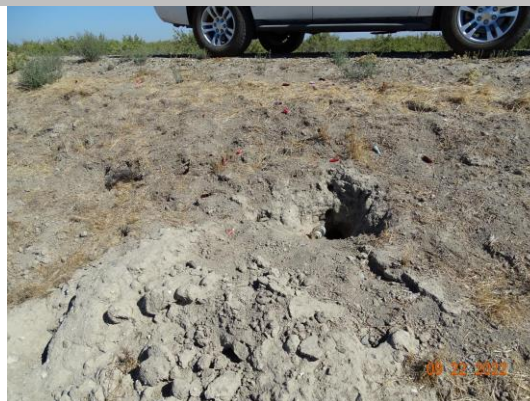
Photo 1 of 1 : FA_2022_NA0010_123_193_20221010_00378.jpg

LM Start	31.17	Rating **	M	Issue No.	193
LM End	31.17	Issue Type +	Ma	Location *	WS
Category	Earthen Levee			GPS Latitude/Longitude	
				Start	End
Item	Animal Control			37.003104 °	37.003104 °
				-120.417833 °	-120.417833 °
DWR ID	DWR_NA0010_05_f_2022_193				
Comment Code					
A3 : No rodents visible, but rodent burrows visible; need to backfill and compact or grout burrows.					
Inspector Comment

View of animal burrow in the waterside slope. (Fall 2022)

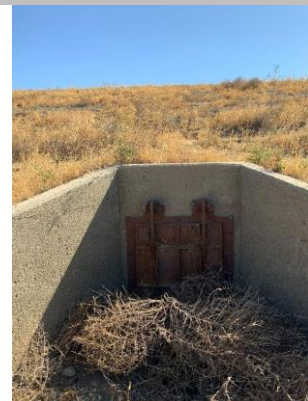
Photo 2 of 2 : UCIP_FA_2022_71080_104287.jpg

WS view from toe: flapgate on concrete headwall at outlet.

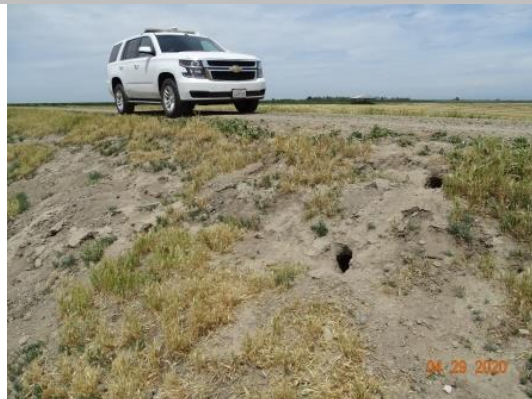
Photo 1 of 1 : FA_2022_NA0010_123_230_20220822_00065.jpg

LM Start	31.66	Rating **	U	Issue No.	230
LM End	31.66	Issue Type +	Ma	Location *	WS
Category	Earthen Levee			GPS Latitude/Longitude	
				Start	End
Item	Animal Control			36.997828 °	36.997828 °
				-120.411920 °	-120.411920 °
DWR ID	DWR_NA0010_05_s_2020_230				
Comment Code					
A3 : No rodents visible, but rodent burrows visible; need to backfill and compact or grout burrows.					
Inspector Comment					
Several rodent burrows in the waterside slope and shoulder.

Rodent burrows in the waterside slope. (Spring 2020)

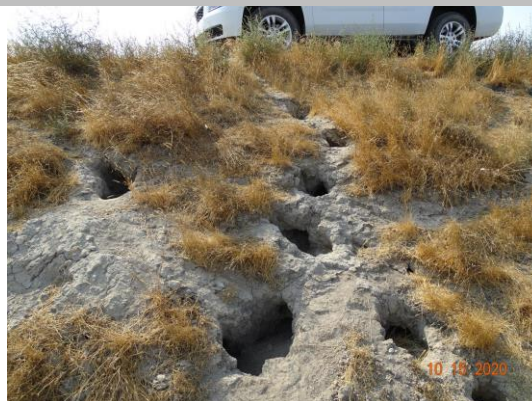
Photo 1 of 1 : FA_2022_NA0010_123_129_20220822_00029.jpg

LM Start	31.70	Rating **	U	Issue No.	129
LM End	31.73	Issue Type +	Ma	Location *	LS
Category	Earthen Levee			GPS Latitude/Longitude	
				Start	End
Item	Animal Control			36.997410 °	36.997108 °
				-120.411437 °	-120.411092 °
DWR ID	DWR_NA0010_05_f_2020_129				
Comment Code					
A3 : No rodents visible, but rodent burrows visible; need to backfill and compact or grout burrows.					
Inspector Comment

Several large rodent holes noted at this location. (Fall 2020)

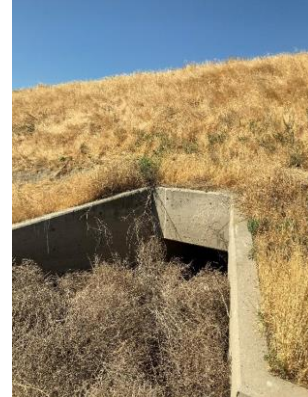
Photo 1 of 2 : UCIP_FA_2022_71081_104280.jpg

Comment Code						
Inspector Comment						
DS_ID:19699 FS_ID:71081 EP_NO: N/A Repair Type: Non-Urgent EVAL Issue: 11, Maintenance Compliance Issue Crossing Status: Found UCIP Comments: 06/24/2021 The record has been upgraded from No Action Needed to Non-Urgent. Limited inspection of LS due to dense vegetation; recommend removal. Wooden planks propping flapgate on WS open; recommend removal before flood season. No permit was found authorizing this encroachment. CVFPB will need to review crossing to determine owner. The UCIP inspection was completed with GEI staff, H.Dunn. (P.Espinoza – GEI) FIELD_STRUCT_DESC: 48-inch by 36-inch reinforced concrete box gravity drainage culvert (RCBC) through the levee, 14.5 feet below the crown. Flap gate on the waterside (WS) end. Concrete U-shaped headwall on each end. [Additional Reference(s): DWR Levee Log, 2002, (HLM 31.64). USACE San Joaquin O&M Manual, Unit No. 601, Part No. 1, 1967, Amended in 1978, Revised 20 June 1985, (HLM 31.64). DWR As-Built Specification No. 64-42, Sheet No. 8, 13 August 1964, (HLM 31.64)]. FS Date: 6/24/2021 2:15:00 PM

LS view from toe: concrete headwall at inlet.

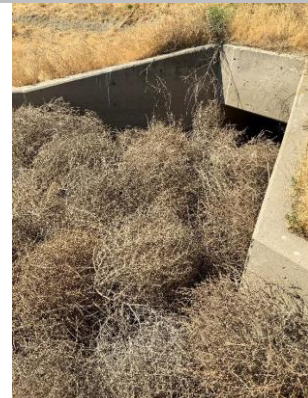
Photo 2 of 2 : UCIP_FA_2022_71081_104281.jpg

LS view from toe: closeup of inlet.

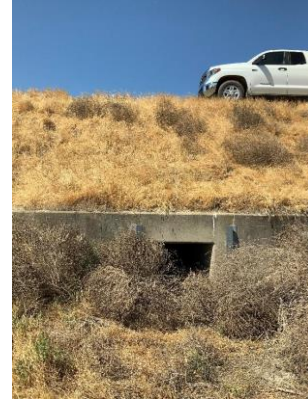
Photo 1 of 2 : UCIP_FA_2022_71082_104271.jpg

Comment Code					
Inspector Comment					
DS_ID:19700 FS_ID:71082 EP_NO: N/A Repair Type: Non-Urgent EVAL Issue: 11, Maintenance Compliance Issue Crossing Status: Found UCIP Comments: 06/23/2021 The record remains Non-Urgent. Some tumbleweed buildup at LS inlet and WS flapgate, recommend removal. No permit was found authorizing this encroachment. CVFPB will need to review crossing to determine owner. The UCIP inspection was completed with GEI staff, H.Dunn. (P.Espinoza – GEI) 04/01/2014 Dense vegetation limits the inspector's visibility to identify signs of pipe failure (leaks) along the landward slope. Recommend removing vegetation along pipe alignment to conduct proper inspection of structure. (W. Wylie - DWR UCIP) FIELD_STRUCT_DESC: 30-inch by 30-inch reinforced concrete box gravity drainage culvert (RCBC) through the levee, 13.0 feet below the crown. Flap gate on the waterside (WS) end. Concrete headwall on the landside (LS) end with flashboard attachment. Concrete U-shaped headwall on the WS end. [Additional Reference(s): DWR Levee Log, 2002, (HLM 31.69). USACE San Joaquin O&M Manual, Unit No. 601, Part No. 1, 1967, Amended in 1978, Revised 20 June 1985, (HLM 31.71). DWR As-Built Specification No. 64-42, Sheet No. 8, 13 August 1964, (HLM 31.71)]. FS Date: 6/23/2021 2:03:00 PM

LS view from toe: concrete headwall and inlet.

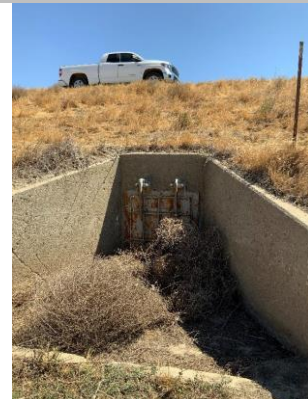
Photo 2 of 2 : UCIP_FA_2022_71082_104273.jpg

WS view from toe: flapgate on concrete headwall at outlet.

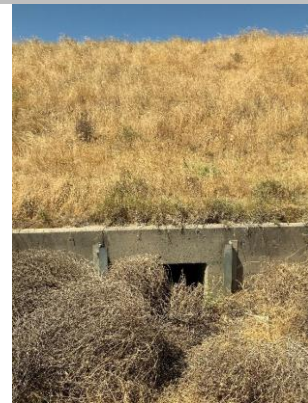
Photo 1 of 2 : UCIP_FA_2022_71083_104264.jpg

Comment Code						
Inspector Comment						
DS_ID:19701 FS_ID:71083 EP_NO: N/A Repair Type: Non-Urgent EVAL Issue: 11, Maintenance Compliance Issue Crossing Status: Found UCIP Comments: 06/23/2021 The record remains Non-Urgent. Limited inspection of LS inlet due to dense vegetation; recommend removal. No permit was found authorizing this encroachment. CVFPB will need to review crossing to determine owner. The UCIP inspection was completed with GEI staff, H.Dunn. (P.Espinoza – GEI) 04/01/2014 Some silt buildup inside culvert. (W. Wylie - DWR UCIP) FIELD_STRUCT_DESC: 30-inch by 30-inch reinforced concrete box gravity drainage culvert (RCBC) through the levee, 14.2 feet below the crown. Flap gate on the waterside (WS) end. Concrete headwall on the landside (LS) end with flashboard attachment. Concrete U-shaped headwall on the WS end. [Additional Reference(s): DWR Levee Log, 2002, (HLM 32.22). USACE San Joaquin O&M Manual, Unit No. 601, Part No. 1, 1967, Amended in 1978, Revised 20 June 1985, (HLM 32.22). DWR As-Built Specification No. 64-42, Sheet No. 8, 13 August 1964, (HLM 32.22)]. FS Date: 6/23/2021 1:18:00 PM

LS view from toe: concrete headwall at inlet.

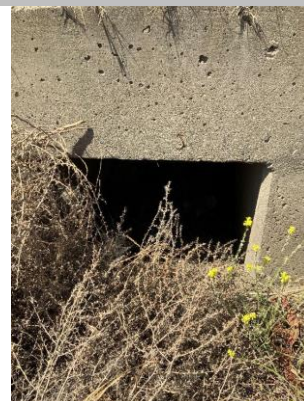
Photo 2 of 2 : UCIP_FA_2022_71083_104265.jpg

LS view from toe: closeup of inlet.

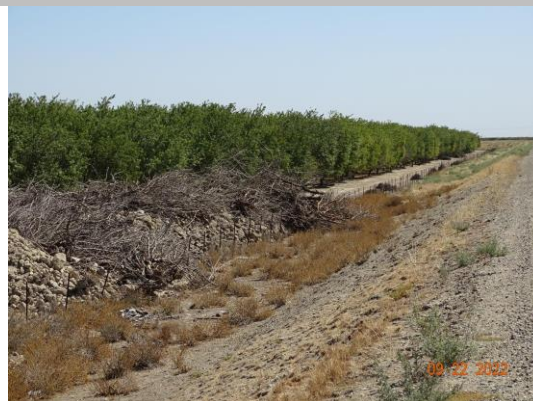
Photo 1 of 1 : FA_2022_NA0010_123_196_20221010_00379.jpg

LM Start	33.08	Rating **	M	Issue No.	196
LM End	33.08	Issue Type +	En	Location *	LS
Category	Earthen Levee			GPS Latitude/Longitude	
				Start	End
Item	Encroachments			36.981182 °	36.981182 °
				-120.393448 °	-120.393448 °
DWR ID	DWR_NA0010_05_f_2022_196				
Comment Code					
DE : Debris					
Inspector Comment					
Tree prunings and material are beginning to encroach the levee easement and landside toe.

Debris encroaching into the landside easement and toe. (Fall 2022)

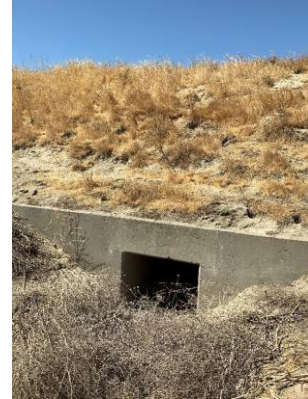
Photo 1 of 2 : UCIP_FA_2022_71084_104257.jpg

DS_ID:19702
FS_ID:71084
EP_NO: N/A
Repair Type: Non-Urgent
EVAL Issue: 11, Maintenance Compliance Issue
Crossing Status: Found
UCIP Comments: 06/23/2021 The record remains Non-Urgent. Some tumbleweed buildup over WS flapgate and LS inlet, recommend removal. No permit was found authorizing this encroachment. CVFPB will need to review crossing to determine owner. The UCIP inspection was completed with GEI staff, H.Dunn. (P.Espinoza – GEI)

04/01/2014 Dense vegetation limits the inspector's visibility to identify signs of pipe failure (leaks) along the landward slope. Recommend removing vegetation along pipe alignment to conduct proper inspection of structure. Debris buildup blocking landward headwall--recommend contacting owner to clear debris. (W. Wylie - DWR UCIP)
FIELD_STRUCT_DESC: 30-inch by 30-inch reinforced concrete box gravity drainage culvert (RCBC) through the levee, 12.2 feet below the crown. Flap gate on the waterside (WS) end. Concrete headwall on the landside (LS) end. Concrete U-shaped headwall on the WS end.
[Additional Reference(s): DWR Levee Log, 2002, (HLM 33.02). USACE San Joaquin O&M Manual, Unit No. 601, Part No. 1, 1967, Amended in 1978, Revised 20 June 1985, (HLM 33.01). DWR As-Built Specification No. 64-42, Sheet No. 9, 13 August 1964, (HLM 33.01)].
FS Date: 6/23/2021 12:49:00 PM

LS view from toe: concrete headwall at inlet.

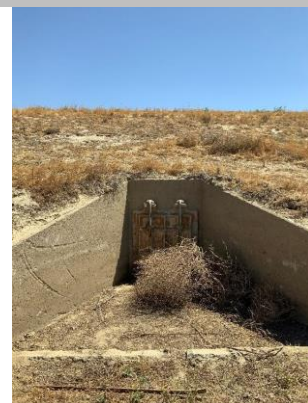
Photo 2 of 2 : UCIP_FA_2022_71084_104259.jpg

WS view from toe: flapgate on concrete headwall at outlet.

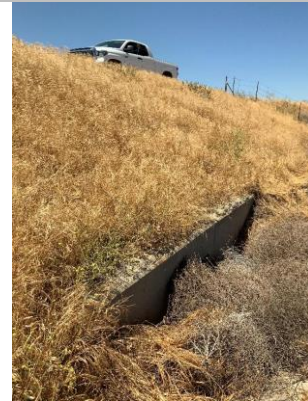
Photo 1 of 2 : UCIP_FA_2022_71085_104252.jpg

Comment Code						
Inspector Comment						
DS_ID:19703 FS_ID:71085 EP_NO: N/A Repair Type: Non-Urgent EVAL Issue: 11, Maintenance Compliance Issue Crossing Status: Found UCIP Comments: 06/24/2021 The record remains Non-Urgent. Limited inspection of LS and WS due to dense vegetation; recommend removal. No permit was found authorizing this encroachment. CVFPB will need to review crossing to determine owner. The UCIP inspection was completed with GEI staff, H.Dunn. (P.Espinoza – GEI) 04/01/2014 Dense vegetation limits the inspector's visibility to identify signs of pipe failure (leaks) along the slopes. Recommend removing vegetation along pipe alignment to conduct proper inspection of structure. (W. Wylie - DWR UCIP) FIELD_STRUCT_DESC: 30-inch by 30-inch reinforced concrete box gravity drainage culvert (RCBC) through the levee, 13.9 feet below the crown. Flap gate on the waterside (WS) end. Concrete headwall on the landside (LS) end. Concrete U-shaped headwall on the WS end. [Additional Reference(s): DWR Levee Log, 2002, (HLM 33.72). USACE San Joaquin O&M Manual, Unit No. 601, Part No. 1, 1967, Amended in 1978, Revised 20 June 1985, (HLM 33.72). DWR As-Built Specification No. 64-42, Sheet No. 9, 13 August 1964, (HLM 33.72)]. FS Date: 6/24/2021 12:30:00 PM

LS view from toe: concrete headwall and inlet.

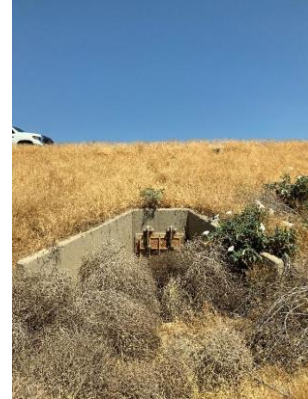
Photo 2 of 2 : UCIP_FA_2022_71085_104250.jpg

WS view from toe: flapgate on concrete headwall.

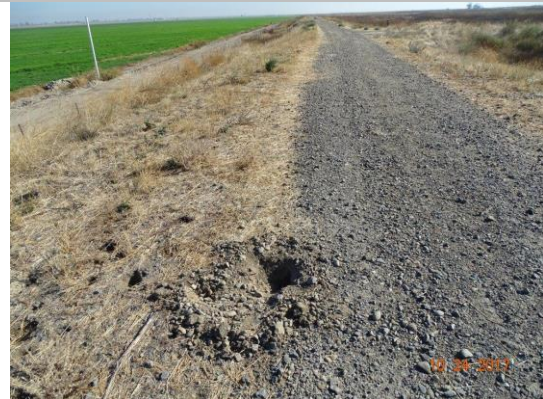
Photo 1 of 1 : FA_2022_NA0010_123_130_20220822_00030.jpg

LM Start	33.82	Rating **	M	Issue No.	130
LM End	33.82	Issue Type +	Ma	Location *	LS
Category	Earthen Levee			GPS Latitude/Longitude	
				Start	End
Item	Animal Control			36.976849 °	36.976849 °
				-120.382393 °	-120.382393 °
DWR ID	DWR_NA0010_05_f _ 2017_130				
Comment Code					
A3 : No rodents visible, but rodent burrows visible; need to backfill and compact or grout burrows.					
Inspector Comment

Looking east at the landside shoulder.

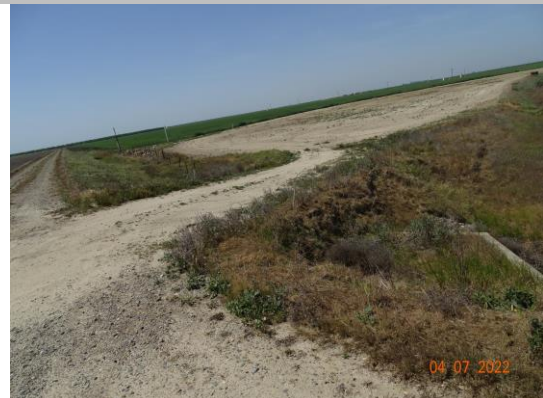
Photo 1 of 1 : FA_2022_NA0010_123_189_20220822_00063.jpg

LM Start	34.60	Rating **	M	Issue No.	189
LM End	34.60	Issue Type +	En	Location *	LS
Category	Earthen Levee			GPS Latitude/Longitude	
				Start	End
Item	Encroachments			36.978525 °	36.978525 °
				-120.368661 °	-120.368661 °
DWR ID	DWR_NA0010_05_s_2022_189				
Comment Code					
RA : Ramp					
Inspector Comment

View of ramp on the landside slope. (Spring 2022)

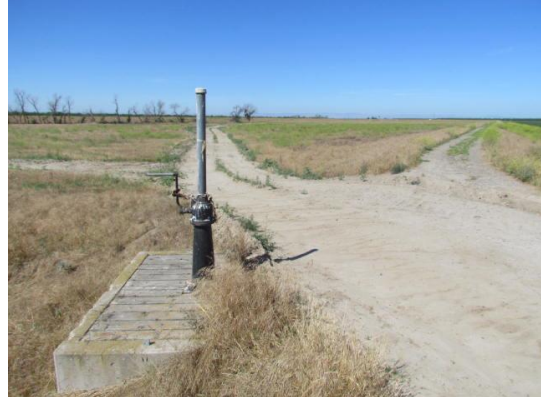
Photo 1 of 1 : FA_2022_NA0010_123_11_20220822_00008.jpg

LM Start	34.61	Rating **	M	Issue No.	11
LM End	34.61	Issue Type +	En	Location *	WS
Category	Earthen Levee			GPS Latitude/Longitude	
				Start	End
Item	Encroachments			36.978523 °	36.978523 °
				-120.368520 °	-120.368520 °
DWR ID	DWR_NA0010_05_s_2012_11				
Comment Code					
RA : Ramp					
Inspector Comment					
There is an unauthorized ramp on waterside slope. Landowner cut unauthorized ramp on waterside slope and levee crown.

Looking west at ramp on waterward slope.

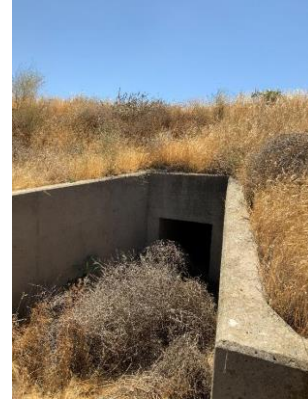
Photo 1 of 2 : UCIP_FA_2022_71086_104243.jpg

DS_ID:19755
FS_ID:71086
EP_NO: N/A
Repair Type: Non-Urgent
EVAL Issue: 11, Maintenance Compliance Issue
Crossing Status: Found
UCIP Comments: 06/24/2021 The record remains Non-Urgent. Limited inspection of WS and LS due to dense vegetation, recommend removal. No permit was found authorizing this encroachment. CVFPB will need to review crossing to determine owner. The UCIP inspection was completed with GEI staff, H.Dunn. (P.Espinoza – GEI)

04/01/2014 Dense vegetation limits the inspector's visibility to identify signs of pipe failure (leaks) along the landward slope. Recommend removing vegetation along pipe alignment to conduct proper inspection of structure. Debris buildup visible on waterward headwall--recommend contacting owner to clear pipe. (W. Wylie - DWR UCIP)
FIELD_STRUCT_DESC: [Chowchilla Canal Irrigation Structure] 36-inch by 36-inch reinforced concrete box gravity irrigation culvert (RCBC) through the levee, 9.7 feet below the crown. Slide gate in a 56-inch by 91-inch concrete riser unit on the waterside (WS) slope. Concrete U-shaped headwall on each end. Landside channel cobble revetted for 8 feet. [Additional Reference(s): DWR Levee Log, 2002, (HLM 34.51). USACE San Joaquin O&M Manual, Unit No. 601, Part No. 1, 1967, Amended in 1978, Revised 20 June 1985, (HLM 34.51). DWR As-Built Specification No. 64-42, Sheet No. 10, 13 August 1964, (HLM 34.51)].

LS view from toe: concrete headwall and inlet.

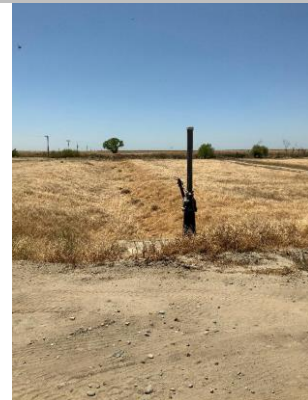
Photo 2 of 2 : UCIP_FA_2022_71086_104242.jpg

WS view from crown. Slide gate in concrete riser visible in background.

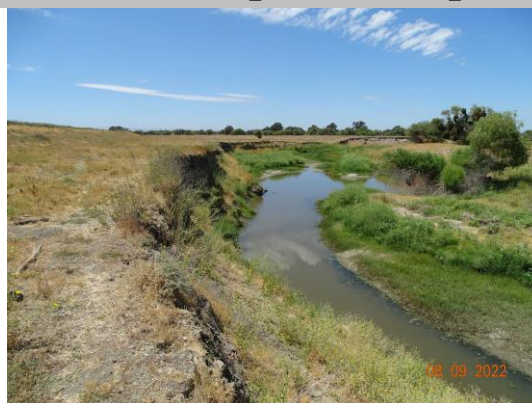
Photo 1 of 3 : SJR2022_NA0010U06LM0.12_3.JPG

LM Start	0.10	Rating **	U	Issue No.	167
LM End	0.14	Issue Type +	Ma	Location *	
Category	Supplemental			GPS Latitude/Longitude	
				Start	End
Item	DWR Erosion Survey			37.275701 °	37.275701 °
				-120.823773 °	-120.823773 °
DWR ID	NA0010U06RM0.41				
Comment Code					
Inspector Comment					
Site ID: NA0010U06RM0.41 08/09/2022: The site was discovered by the LMA and visited during the annual field survey. There is a 20-ft vertical scarp running along the bank and encroaching into the extended levee prism. The berm is 10-12 ft wide.

8/9/2022: View of the erosion looking downstream.

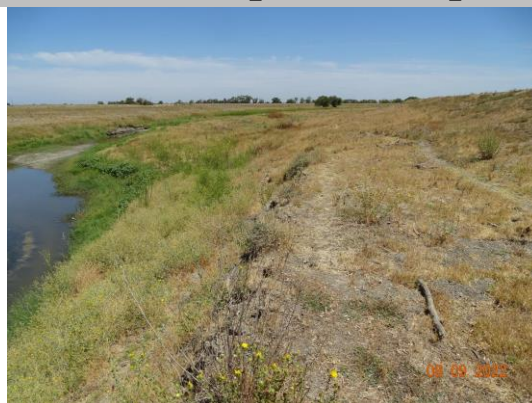
Photo 2 of 3 : SJR2022_NA0010U06LM0.12_8.JPG

8/9/2022: View of the erosion looking upstream.

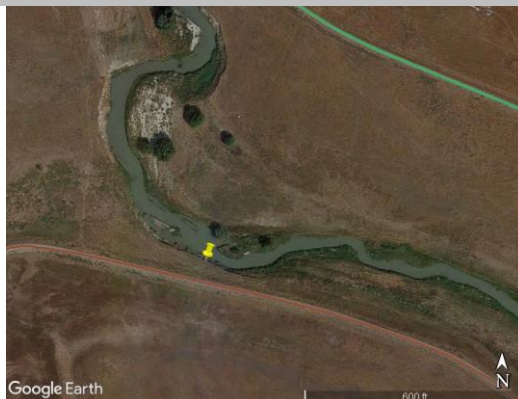
Photo 3 of 3 : SJR2022_NA0010U06LM0.12_GE.JPG

9/13/2022: Aerial view of the erosion site (Google Earth Imagery from 9/27/2020).

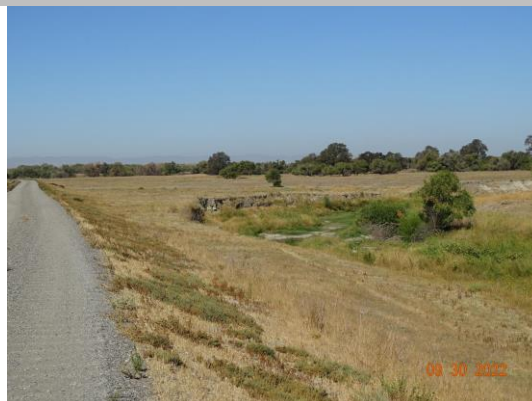
Photo 1 of 1 : FA_2022_NA0010_124_106_20221010_00239.jpg

LM Start	0.10	Rating **	U	Issue No.	106
LM End	0.17	Issue Type +	Ma	Location *	WS
Category	Earthen Levee			GPS Latitude/Longitude	
				Start	End
Item	Erosion / Bank Caving			37.275758 °	37.275541 °
				-120.824067 °	-120.822833 °
DWR ID	DWR_NA0010_06_f_2022_106				
Comment Code					
E2 : Schedule repair of erosion site prior to the next inspection.					
Inspector Comment					
Erosion is approximately 10 feet from toe. It is within the theoretical prism. Erosion is approximately 20 feet in height and 250 feet in length.

Erosion on the waterside toe has cut into the theoretical prism. (Fall 2022)

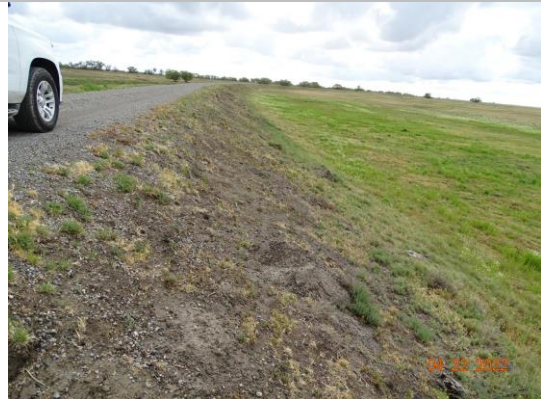
Photo 1 of 1 : FA_2022_NA0010_124_147_20220822_00059.jpg

LM Start	0.14	Rating **	M	Issue No.	147
LM End	0.14	Issue Type +	Ma	Location *	LS
Category	Earthen Levee			GPS Latitude/Longitude	
				Start	End
Item	Animal Control			37.275637 °	37.275637 °
				-120.823438 °	-120.823438 °
DWR ID	DWR_NA0010_06_s_2022_147				
Comment Code					
A3 : No rodents visible, but rodent burrows visible; need to backfill and compact or grout burrows.					
Inspector Comment

View of rodent burrows on the landside slope. (Spring 2022)

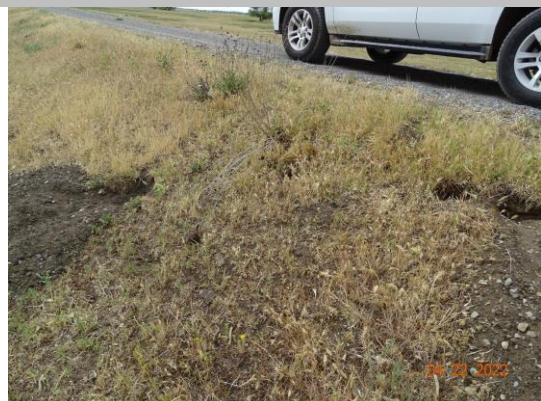
Photo 1 of 1 : FA_2022_NA0010_124_148_20220822_00060.jpg

LM Start	0.43	Rating **	M	Issue No.	148
LM End	0.43	Issue Type +	Ma	Location *	WS
Category	Earthen Levee			GPS Latitude/Longitude	
				Start	End
Item	Animal Control			37.273651 °	37.273651 °
				-120.818813 °	-120.818813 °
DWR ID	DWR_NA0010_06_s_2022_148				
Comment Code					
A1 : Exterminate rodents and backfill and compact or grout burrows.					
Inspector Comment

View of active rodent burrows on the waterside slope. (Spring 2022)

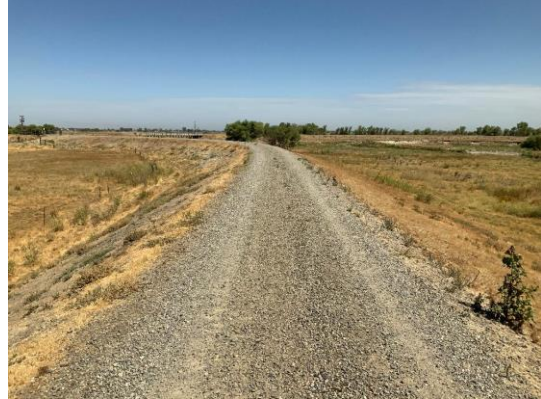
Photo 1 of 3 : UCIP_FA_2022_71092_102876.jpg

Comment Code						
Inspector Comment						
DS_ID:19816 FS_ID:71092 EP_NO: N/A Repair Type: Non-Urgent EVAL Issue: Crossing Status: Found UCIP Comments: 07/27/2021 The record remains Non-Urgent. LS pipe inlet is blocked by barbed wire, limited access and inspection. No permit was found authorizing this encroachment. CVFPB will need to review crossing to determine owner. The UCIP inspection was completed with GEI staff, P. Espinoza. (H. Dunn – GEI) 04/18/2014 Landward side blocked--need to contact owner to determine status of crossing. (O. Magana - DWR UCIP) FIELD_STRUCT_DESC: 24-inch corrugated metal gravity drainage pipe (CMP) through the levee, 16.2 feet below the crown. Flap gate on the waterside (WS) end. Concrete U-shaped headwall on each end. [Additional Reference(s): DWR Levee Log, 2002, (HLM 0.86). USACE San Joaquin O&M Manual, Unit No. 601, Part No. 1, 1967, Amended in 1978, Revised 20 June 1985, (HLM 0.86). DWR As-Built Specification No. 61-01, Sheet No. 45, 7 March 1961, (HLM 0.86)]. FS Date: 7/27/2021

Levee crown.

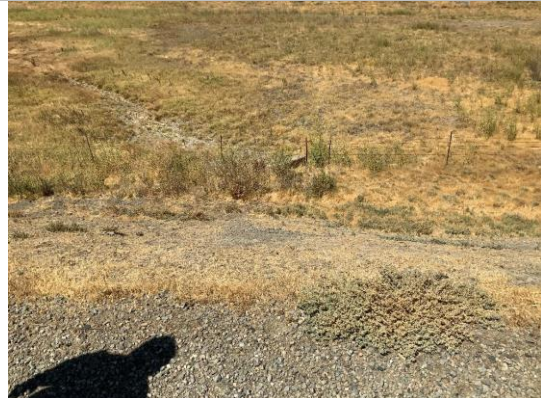
Photo 2 of 3 : UCIP_FA_2022_71092_102877.jpg

LS view: Toe from crown.

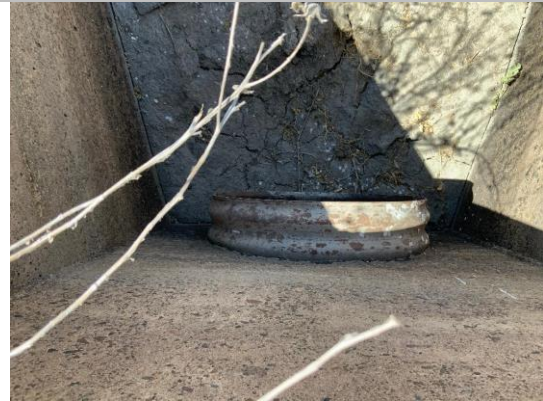
Photo 3 of 3 : UCIP_FA_2022_71092_102879.jpg

LS view: Top view of pipe inlet at toe.

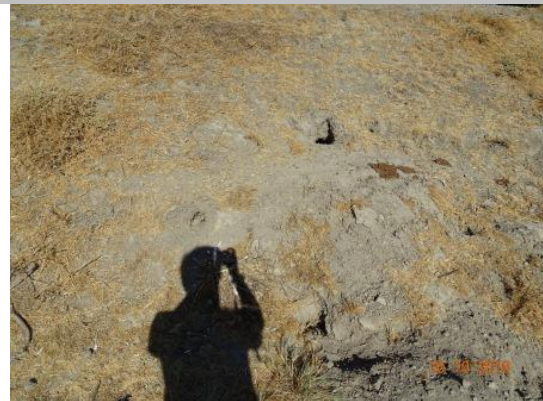
Photo 1 of 1 : FA_2022_NA0010_124_93_20220822_00026.jpg

LM Start	1.18	Rating **	U	Issue No.	93
LM End	1.18	Issue Type +	Ma	Location *	LS
Category	Earthen Levee			GPS Latitude/Longitude	
				Start	End
Item	Animal Control			37.267101 °	37.267101 °
				-120.809603 °	-120.809603 °
DWR ID	DWR_NA0010_06_f_2018_93				
Comment Code					
A1 : Exterminate rodents and backfill and compact or grout burrows.					
Inspector Comment					
Several rodent burrows including large burrows were observed at this location.

View of landside slope. (Fall 2018)

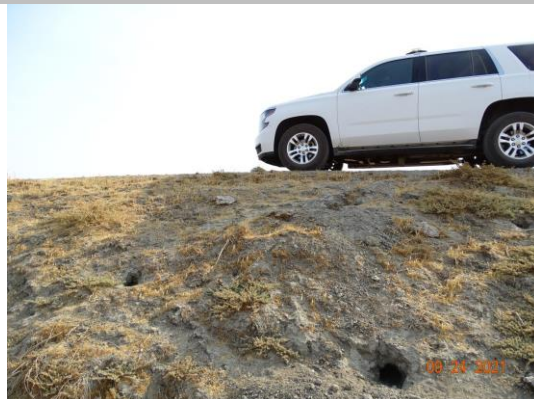
Photo 1 of 1 : FA_2022_NA0010_124_127_20220822_00045.jpg

LM Start	1.52	Rating **	M	Issue No.	127
LM End	1.52	Issue Type +	Ma	Location *	LS
Category	Earthen Levee			GPS Latitude/Longitude	
				Start	End
Item	Animal Control			37.263176 °	37.263176 °
				-120.805983 °	-120.805983 °
DWR ID	DWR_NA0010_06_f_2021_127				
Comment Code					
A3 : No rodents visible, but rodent burrows visible; need to backfill and compact or grout burrows.					
Inspector Comment

View of rodent burrows in the landside slope. (Fall 2021)

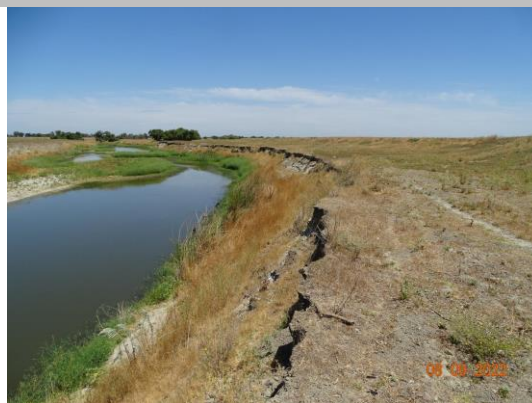
Photo 1 of 3 : UCIP_FA_2022_70636_92086.jpg

Overview of levee crown looking upstream towards pipe crossing. Pipe is locate near gate entrance.

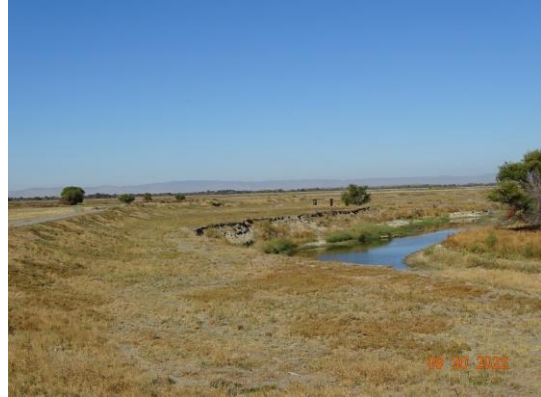
Photo 3 of 3 : UCIP_FA_2022_70636_92089.jpg

LM Start	0.34	Rating **	M	Issue No.	1186
LM End	0.34	Issue Type +	Ma	Location *	
Category	Supplemental		GPS Latitude/Longitude		
			Start	End	
Item	DWR UCIP LMA Responsibility		37.344705 °	37.344705 °	
			-120.962176 °	-120.962176 °	
DWR ID	19651

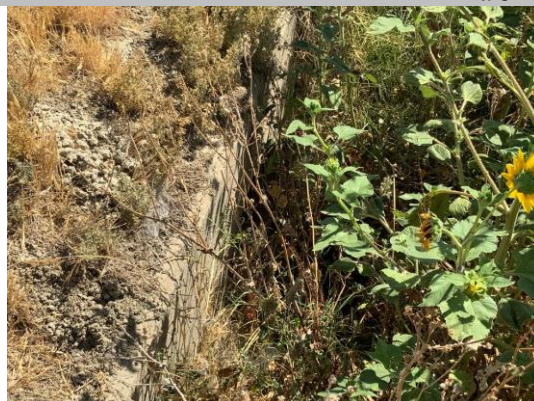
Overview of levee looking US

Levee Inspection Report By Mile - Fall 2022

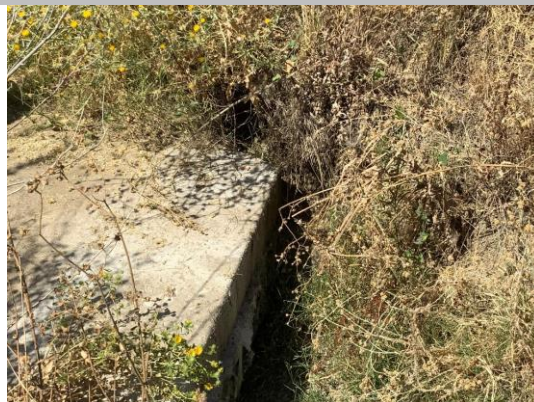
Waterway	Bank	Unit Miles	Inspection Start/End	Inspector
Unit No. 01 San Joaquin River	Right	22.52	09/20/2022 09/20/2022	Corey Fujitani

Photo 2 of 3 : UCIP_FA_2022_70637_90530.jpg

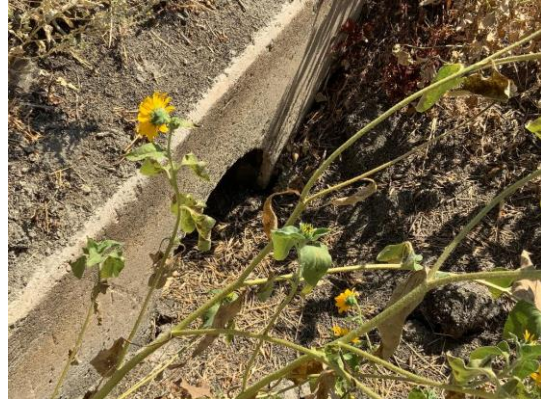
LM Start	0.36	Rating **	M	Issue No.	95
LM End	0.36	Issue Type +	Ma	Location *	LS
Category	Earthen Levee			GPS Latitude/Longitude	
				Start	End
Item	Animal Control			37.344312 °	37.344312 °
				-120.962361 °	-120.962361 °
DWR ID	DWR_NA0010_01_f_2020_95				
Comment Code					
A3 : No rodents visible, but rodent burrows visible; need to backfill and compact or grout burrows.					
Inspector Comment

* Location	** Rating	+ Issue Type
LS : Land Side N/A : Not Applicable	A : Acceptable	Ma : Maintenance Deficiency
WS : Water Side	M : Minimally Acceptable	Ob : Design & System Obsolescence
CR : Crown	U : Unacceptable	En : Enforcement
	N : Not Inspected/Rated	
	C : Corrected	
	A/W : Acceptable but Monitor & Maintain

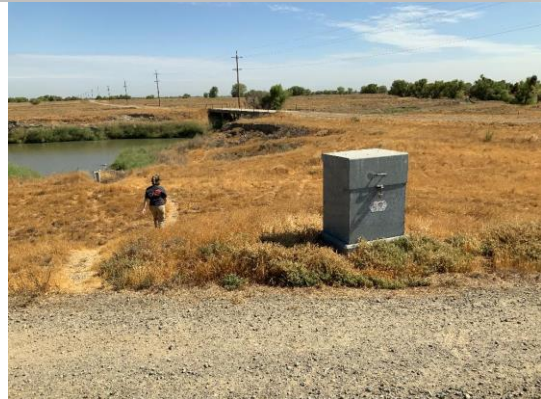
Comment Code

Photo 3 of 3 : UCIP_FA_2022_70639_90544.jpg

DS_ID:19585
 FS_ID:70640
 EP_NO: N/A
 Repair Type: Urgent
 EVAL Issue: 1, Pipe Integrity
 Crossing Status: Found
 UCIP Comments: 10/06/2020 Record has been updated from Non-Urgent to Urgent. DWR DMP has found integrity issues, LOF between 5 and 6. Scour visible behind the concrete headwall on the LS toe. Recommend monitoring crossing until funding becomes available to addressed. No permit was found authorizing this encroachment. CVFPB will need to review crossing to determine owner. (B. Singh - GEI, O. Magana - DWR UCIP)04/08/2014 Moderate erosion around headwall on landward toe. May or may not be an issue. Need to contact owner to determine status of crossing and to address erosion issue on landward side. (W. Wylie - DWR UCIP)
 FIELD_STRUCT_DESC: 24-inch corrugated metal (CM) gravity drainage pipe through the levee, 9.0 feet below the crown. Flap gate on the waterside (WS) end. Brass cap No. 108 bench mark (BM) on the headwall on the landside (LS). [Additional Reference(s): DWR Levee Log, 2002, (HLM 0.96). USACE San Joaquin O&M Manual, Unit No. 601, Part No. 1, (SJR601.1), 1967, Revised 25 May 2011, (HLM 0.95)].

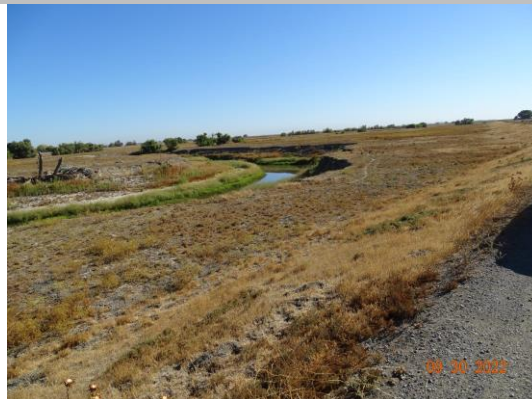
Photo 1 of 1 : FA_2022_NA0010_124_96_20221010_00241.jpg

LM Start	3.62	Rating **	A/W	Issue No.	96
LM End	3.67	Issue Type +	Ma	Location *	WS
Category	Earthen Levee			GPS Latitude/Longitude	
				Start	End
Item	Erosion / Bank Caving			37.251226 °	37.251140 °
				-120.775774 °	-120.774900 °
DWR ID	DWR_NA0010_06_f_2022_96				
Comment Code					
E1 : Note and monitor erosion site.					
Inspector Comment					
Erosion is approximately 30 ft from levee toe, 18 ft in height, and 150 ft in length.

View of erosion on the waterside berm. (Fall 2022)

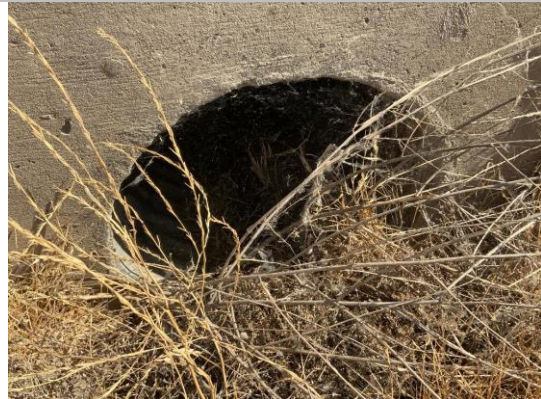
Photo 1 of 2 : UCIP_FA_2022_71102_102984.jpg

DS_ID:19826
FS_ID:71102
EP_NO: N/A
Repair Type: Non-Urgent
EVAL Issue: 5, Pipe Damage
Crossing Status: Found
UCIP Comments: 07/27/2021 The record remains Non-Urgent. DWR DMP internal inspection has found pipe integrity issues. LOF of crossing is between 4.1 and 5. Crossing will be monitored until funding becomes available for rehabilitation. Limited inspection of LS pipe inlet due to vegetation covering it, recommend removal. Exterior liner of WS flapgate is significantly chipping off. No permit was found authorizing this encroachment. CVFPB will need to review crossing to determine owner. The UCIP inspection was completed with GEI staff, P. Espinoza. (H. Dunn – GEI) 04/18/2014 Sediment buildup inside crossing and is visible from landward side. Recommend clearing sediment buildup inside pipe and check wall integrity to determine condition. (O. Magana - DWR UCIP)
FIELD_STRUCT_DESC: 24-inch corrugated metal gravity drainage pipe (CMP) through the levee, 7.0 feet below the crown. Flap gate on the waterside (WS) end. Concrete headwall on each end. [Additional Reference(s): DWR Levee Log, 2002, (HLM 3.78). USACE San Joaquin O&M Manual, Unit No. 601, Part No. 1, 1967, Amended in 1978, Revised 20 June 1985, (HLM 3.77). DWR As-Built Specification No. 61-01, Sheet No. 47, 7 March 1961, (HLM 3.77)].

LS view: Closeup of pipe inlet at toe with vegetation cover.

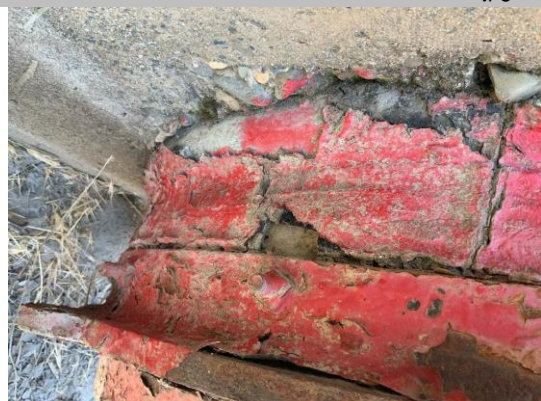
Photo 2 of 2 : UCIP_FA_2022_71102_102980.jpg

WS view: Closeup of liner deterioration on flapgate at toe.

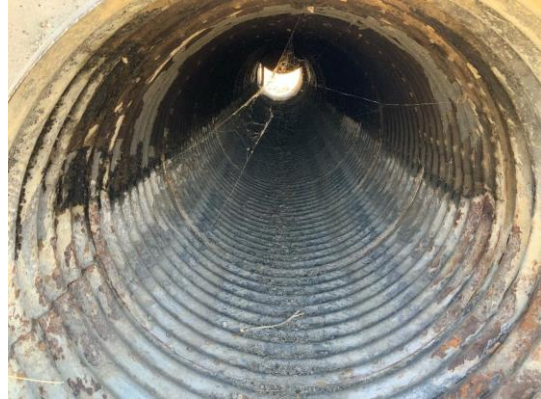
Photo 1 of 2 : UCIP_FA_2022_71103_102997.jpg

DS_ID:19827
FS_ID:71103
EP_NO: N/A
Repair Type: Non-Urgent
EVAL Issue: 5, Pipe Damage
Crossing Status: Found
UCIP Comments: 07/27/2021 The record remains Non-Urgent. DWR DMP internal inspection has found pipe integrity issues. LOF of crossing is between 4.1 and 5. Crossing will be monitored until funding becomes available for rehabilitation. No permit was found authorizing this encroachment. CVFPB will need to review crossing to determine owner. The UCIP inspection was completed with GEI staff, P. Espinoza. (H. Dunn – GEI) 04/18/2014 Sediment buildup inside crossing and is visible from landward side. Recommend clearing sediment buildup inside pipe and check wall integrity to determine condition. (O. Magana - DWR UCIP)
FIELD_STRUCT_DESC: 36-inch corrugated metal gravity drainage pipe (CMP) through the levee, 6.7 feet below the crown. Slide gate in a 48-inch CMP riser unit on the waterside (WS) slope. [Additional Reference(s): DWR Levee Log, 2002, (HLM 3.98). USACE San Joaquin O&M Manual, Unit No. 601, Part No. 1, 1967, Amended in 1978, Revised 20 June 1985, (HLM 3.97). DWR As-Built Specification No. 61-01, Sheet No. 47, 7 March 1961, (HLM 3.97)].

LS view: Inside pipe inlet at toe.

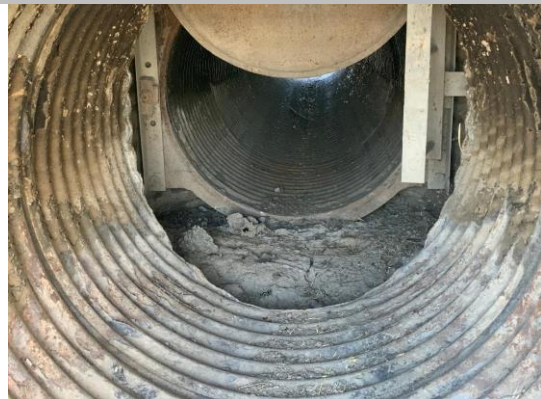
Photo 2 of 2 : UCIP_FA_2022_71103_102993.jpg

WS view: Inside pipe outlet at toe.

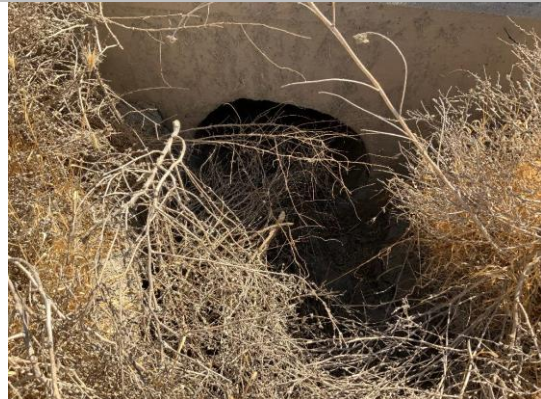
Photo 1 of 1 : UCIP_FA_2022_71104_103008.jpg

Comment Code					
Inspector Comment					
DS_ID:19828 FS_ID:71104 EP_NO: N/A Repair Type: Non-Urgent EVAL Issue: 11, Maintenance Compliance Issue Crossing Status: Found UCIP Comments: 07/27/2021 The record remains Non-Urgent. Limited inspection due to LS pipe inlet being covered by dense tumbleweeds, recommend removal. No permit was found authorizing this encroachment. CVFPB will need to review crossing to determine owner. The UCIP inspection was completed with GEI staff, P. Espinoza. (H. Dunn – GEI) 04/18/2014 Dense vegetation limits the inspector's visibility to identify signs of pipe condition on landward toe--headwall blocked by dense vegetation. Recommend removing vegetation from landward toe. (O. Magana - DWR UCIP) FIELD_STRUCT_DESC: 24-inch corrugated metal gravity drainage pipe (CMP) through the levee, 10.8 feet below the crown. Flap gate on the waterside (WS) end. Concrete headwall on each end. [Additional Reference(s): DWR Levee Log, 2002, (HLM 4.17). USACE San Joaquin O&M Manual, Unit No. 601, Part No. 1, 1967, Amended in 1978, Revised 20 June 1985, (HLM 4.17). DWR As-Built Specification No. 61-01, Sheet No. 48, 7 March 1961, (HLM 4.17)]. FS Date: 7/27/2021

LS view: Closeup of pipe inlet at toe covered by tumbleweeds.

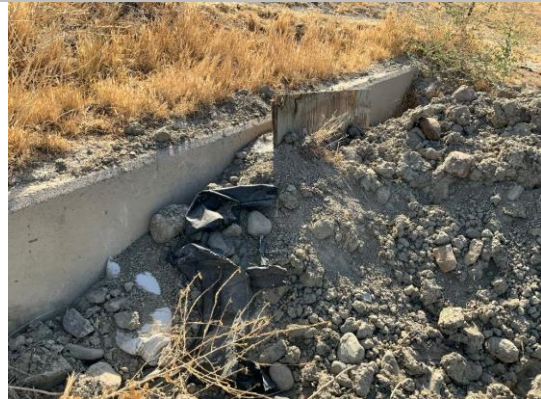
Photo 1 of 2 : UCIP_FA_2022_71106_103032.jpg

DS_ID:19830
FS_ID:71106
EP_NO: N/A
Repair Type: Non-Urgent
EVAL Issue: 4b, Safety Issue
Crossing Status: Found
UCIP Comments: 07/27/2021 The record remains Non-Urgent. WS riser has no cover, causing safety hazard. Limited inspection due to LS pipe inlet completely buried within large dirt pile, recommend clearing out. No permit was found authorizing this encroachment. CVFPB will need to review crossing to determine owner. The UCIP inspection was completed with GEI staff, P. Espinoza. (H. Dunn – GEI) 04/18/2014 Sediment buildup inside crossing visible from landward side. Recommend clearing sediment buildup inside pipe and check wall integrity to determine condition. (O. Magana - DWR UCIP)
FIELD_STRUCT_DESC: 36-inch corrugated metal gravity drainage pipe (CMP) through the levee, 6.9 feet below the crown. Slide gate in a 48-inch CMP riser unit on the waterside (WS) slope. Concrete headwall on the landside (LS) end. Concrete saddle and apron on the WS end. [Additional Reference(s): DWR Levee Log, 2002, (HLM 4.69). USACE San Joaquin O&M Manual, Unit No. 601, Part No. 1, 1967, Amended in 1978, Revised 20 June 1985, (HLM 4.70). DWR As-Built Specification No. 61-01, Sheet No. 48, 7 March 1961, (HLM 4.70)].

LS view: Pile of dirt completely covering pipe inlet at toe.

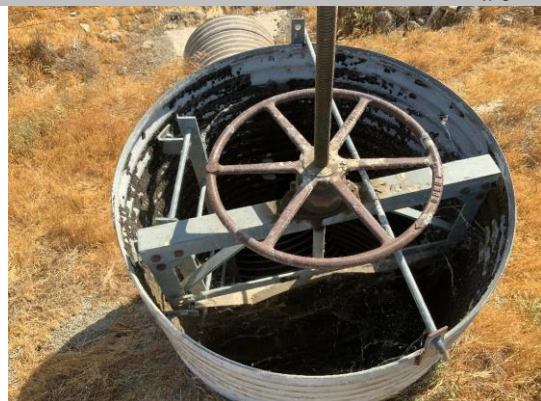
Photo 2 of 2 : UCIP_FA_2022_71106_103027.jpg

WS view: Closeup of riser without lid on slope.

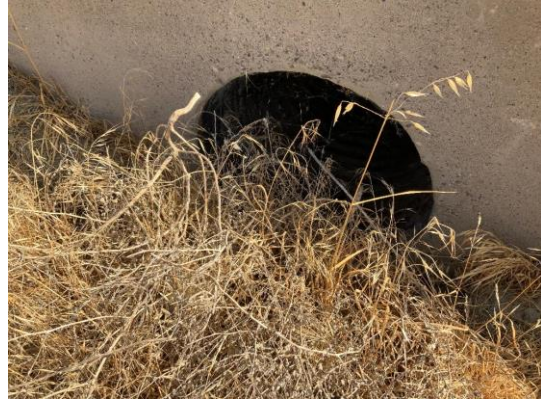
Photo 1 of 1 : UCIP_FA_2022_71107_103040.jpg

Comment Code					
Inspector Comment					
DS_ID:19831 FS_ID:71107 EP_NO: N/A Repair Type: Urgent EVAL Issue: 1, Pipe Integrity Crossing Status: Found UCIP Comments: 07/27/2021 The record has been upgraded from Non-Urgent to Urgent. DWR DMP internal inspection has found pipe integrity issues. LOF of crossing is greater than or equal to 5. Crossing will be monitored until funding becomes available to address the issues. Vegetation over LS pipe inlet, recommend removal. No permit was found authorizing this encroachment. CVFPB will need to review crossing to determine owner. The UCIP inspection was completed with GEI staff, P. Espinoza. (H. Dunn – GEI)04/18/2014 Need to contact owner. Recommend removing tall grass on landward toe to determine condition of crossing from landward side. (O. Magana - DWR UCIP) FIELD_STRUCT_DESC: 24-inch corrugated metal gravity drainage pipe (CMP) through the levee, 11.8 feet below the crown. Flap gate on the waterside (WS) end. Concrete headwall on each end. [Additional Reference(s): DWR Levee Log, 2002, (HLM 4.75). USACE San Joaquin O&M Manual, Unit No. 601, Part No. 1, 1967, Amended in 1978, Revised 20 June 1985, (HLM 4.75). DWR As-Built Specification No. 61-01, Sheet No. 48, 7 March 1961, (HLM 4.75)]. FS Date: 7/27/2021

LS view: Closeup of pipe inlet at toe with minor vegetation growth.

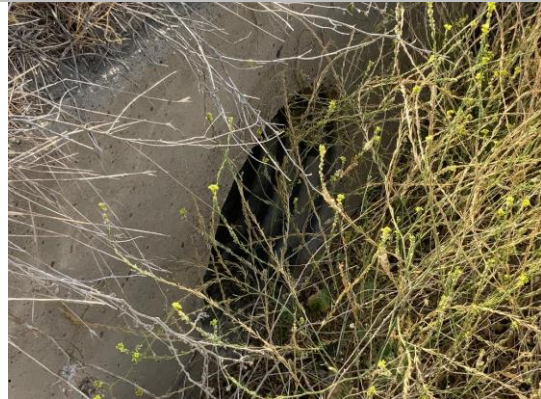
Photo 1 of 1 : UCIP_FA_2022_71108_103049.jpg

Comment Code						
Inspector Comment						
DS_ID:19862 FS_ID:71108 EP_NO: N/A Repair Type: Non-Urgent EVAL Issue: 5, Pipe Damage Crossing Status: Found UCIP Comments: 07/27/2021 The record remains Non-Urgent. DWR DMP internal inspection has found pipe integrity issues. LOF of crossing is between 4.1 and 5. Crossing will be monitored until funding becomes available for rehabilitation. Limited inspection due to dense vegetation over LS pipe inlet, recommend removal. No permit was found authorizing this encroachment. CVFPB will need to review crossing to determine owner. The UCIP inspection was completed with GEI staff, P. Espinoza. (H. Dunn – GEI) 04/18/2014 Dense vegetation limits the inspector's visibility to identify signs of pipe failure (leaks) along the waterward slope. Recommend removing vegetation along waterward slope to conduct proper inspection of structure. Also recommend removing dense vegetation blocking landward headwall. (O. Magana - DWR UCIP) FIELD_STRUCT_DESC: 24-inch corrugated metal gravity drainage pipe (CMP) through the levee, 10.8 feet below the crown. Flap gate on the waterside (WS) end. Concrete headwall on each end. [Additional Reference(s): DWR Levee Log, 2002, (HLM 4.95). USACE San Joaquin O&M Manual, Unit No. 601, Part No. 1, 1967, Amended in 1978, Revised 20 June 1985, (HLM 4.94). DWR As-Built Specification No. 61-01, Sheet No. 48, 7 March 1961, (HLM 4.94)]. FS Date: 7/27/2021

LS view: Closeup of pipe inlet at toe covered by vegetation.

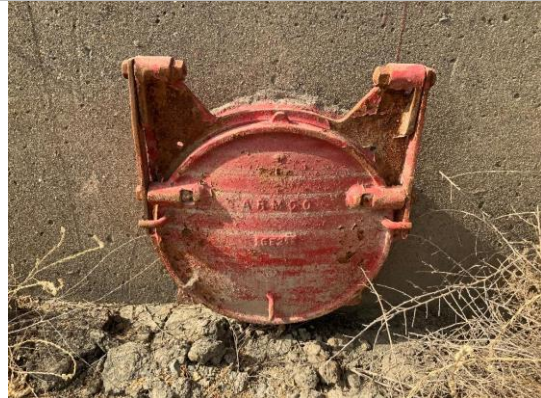
Photo 2 of 2 : UCIP_FA_2022_71109_103066.jpg

WS view: Closeup of flapgate at toe.

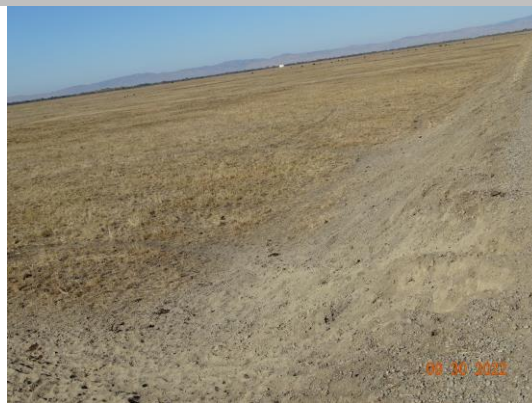
Photo 1 of 1 : FA_2022_NA0010_124_161_20221010_00242.jpg

LM Start	5.42	Rating **	U	Issue No.	161
LM End	5.42	Issue Type +	Ma	Location *	LS
Category	Earthen Levee			GPS Latitude/Longitude	
				Start	End
Item	Erosion / Livestock			37.238729 °	37.238729 °
				-120.748884 °	-120.748884 °
DWR ID	DWR_NA0010_06_f_2022_161				
Comment Code					
E4 : Repair the levee slope damaged by livestock and prevent large animal access.					
Inspector Comment

Deep livestock trail on the landside slope. (Fall 2022)

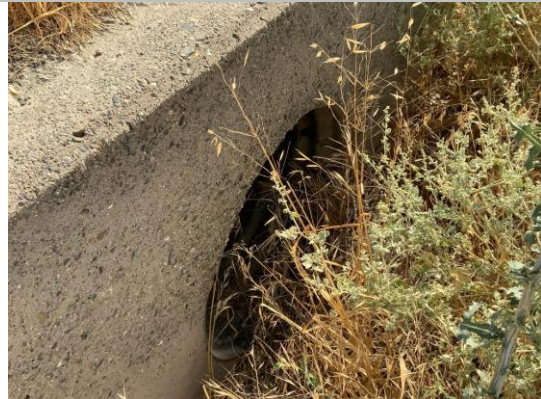
Photo 1 of 1 : UCIP_FA_2022_71110_103078.jpg

Comment Code						
Inspector Comment						
DS_ID:19864 FS_ID:71110 EP_NO: N/A Repair Type: Non-Urgent EVAL Issue: 11, Maintenance Compliance Issue Crossing Status: Found UCIP Comments: 07/27/2021 The record remains Non-Urgent. DWR DMP internal inspection has not found pipe integrity issues. LOF of crossing is less or equal to 4.0. Recommend next video inspection in 5 years. Limited inspection due to vegetation over LS pipe inlet, recommend removal. No permit was found authorizing this encroachment. CVFPB will need to review crossing to determine owner. The UCIP inspection was completed with GEI staff, P. Espinoza. (H. Dunn – GEI) 04/18/2014 Dense vegetation limits the inspector's visibility to identify signs of pipe failure (leaks) along the waterward slope. Recommend removing vegetation along pipe alignment to conduct proper inspection of structure. Also recommend removing excess vegetation at landward headwall. (O. Magana - DWR UCIP) FIELD_STRUCT_DESC: 24-inch corrugated metal gravity drainage pipe (CMP) through the levee, 11.0 feet below the crown. Flap gate on the waterside (WS) end. Concrete headwall on each end. [Additional Reference(s): DWR Levee Log, 2002, (HLM 5.63). USACE San Joaquin O&M Manual, Unit No. 601, Part No. 1, 1967, Amended in 1978, Revised 20 June 1985, (HLM 5.63). DWR As-Built Specification No. 61-01, Sheet No. 49, 7 March 1961, (HLM 5.63)]. FS Date: 7/27/2021

LS view: Closeup of pipe inlet at toe with vegetation growth.

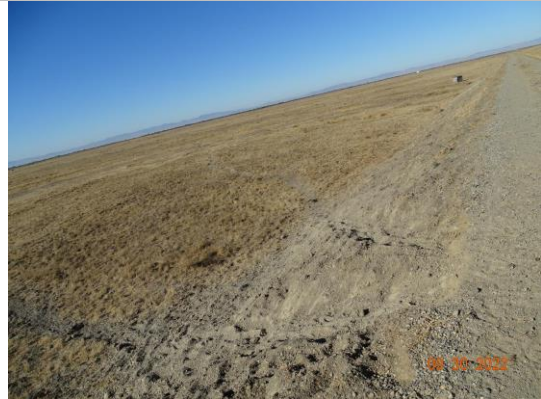
Photo 1 of 1 : FA_2022_NA0010_124_158_20221010_00243.jpg

LM Start	5.60	Rating **	M	Issue No.	158
LM End	5.60	Issue Type +	Ma	Location *	LS
Category	Earthen Levee			GPS Latitude/Longitude	
				Start	End
Item	Erosion / Livestock			37.238539 °	37.238539 °
				-120.745669 °	-120.745669 °
DWR ID	DWR_NA0010_06_f_2022_158				
Comment Code					
E4 : Repair the levee slope damaged by livestock and prevent large animal access.					
Inspector Comment

Livestock trail on the landside slope. (Fall 2022)

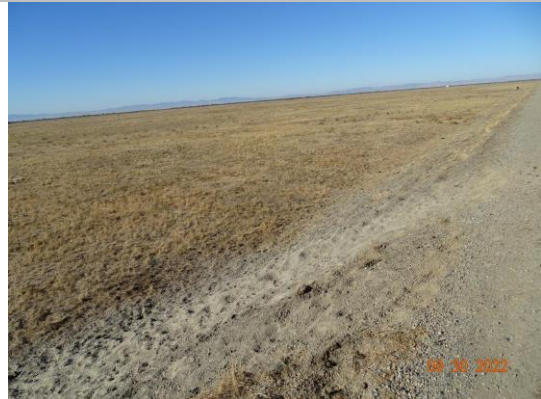
Photo 1 of 1 : FA_2022_NA0010_124_157_20221010_00244.jpg

LM Start	5.68	Rating **	M	Issue No.	157
LM End	5.68	Issue Type +	Ma	Location *	LS
Category	Earthen Levee			GPS Latitude/Longitude	
				Start	End
Item	Erosion / Livestock			37.238459 °	37.238459 °
				-120.744176 °	-120.744176 °
DWR ID	DWR_NA0010_06_f_2022_157				
Comment Code					
E4 : Repair the levee slope damaged by livestock and prevent large animal access.					
Inspector Comment

Livestock damage on landside slope. (Fall 2022)

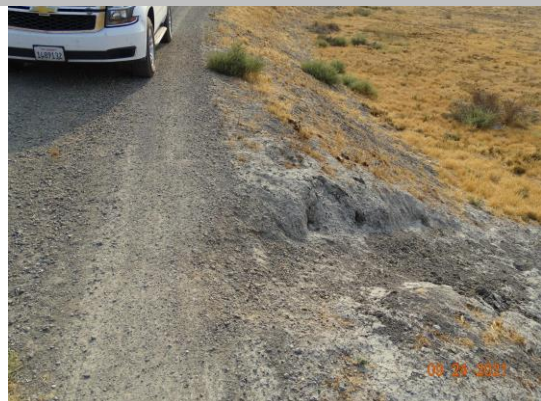
Photo 1 of 1 : FA_2022_NA0010_124_66_20220822_00006.jpg

LM Start	5.77	Rating **	U	Issue No.	66
LM End	5.77	Issue Type +	Ma	Location *	LS
Category	Earthen Levee			GPS Latitude/Longitude	
				Start	End
Item	Erosion / Livestock			37.238354 °	37.238354 °
				-120.742480 °	-120.742480 °
DWR ID	DWR_NA0010_06_f _ 2017_66				
Comment Code					
E4 : Repair the levee slope damaged by livestock and prevent large animal access.					
Inspector Comment					
There is damage to the landside slope and shoulder from livestock.

View of damage to landside slope from livestock traffic looking downstream. (Fall 2021)

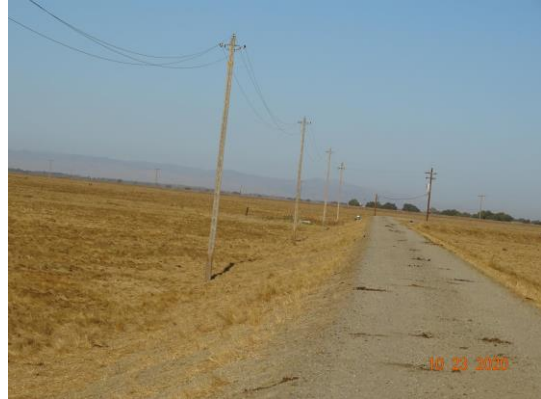
Photo 1 of 1 : FA_2022_NA0010_124_69_20220822_00009.jpg

LM Start	5.93	Rating **	M	Issue No.	69
LM End	7.09	Issue Type +	En	Location *	LS
Category	Earthen Levee			GPS Latitude/Longitude	
				Start	End
Item	Encroachments			37.236936 °	37.226800 °
				-120.740384 °	-120.724736 °
DWR ID	DWR_NA0010_06_s_2022_69				
Comment Code					
PO : Pole					
Inspector Comment					
There are several PG&E poles within this section at the landside toe and slope.

Looking downstream at PG&E poles on the landside slope and toe. (Fall 2020)

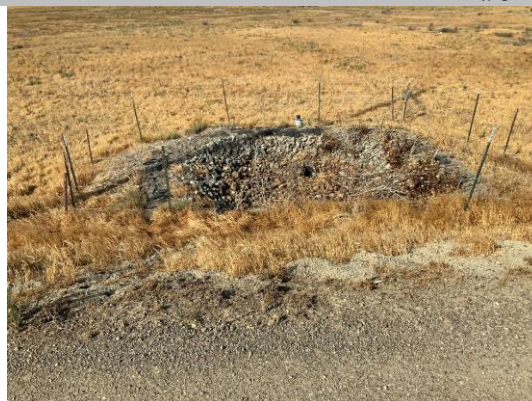
Photo 2 of 3 : UCIP_FA_2022_71111_103093.jpg

LS view: Toe from crown.

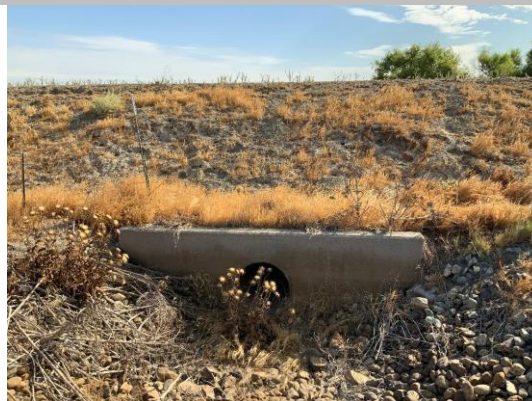
Photo 3 of 3 : UCIP_FA_2022_71111_103094.jpg

LS toe: Headwall and slope from toe.
