Flood Control Project Maintenance Levee Inspections

Fall 2022 Levee Maintenance Deficiency Summary Report

San Joaquin River Basin

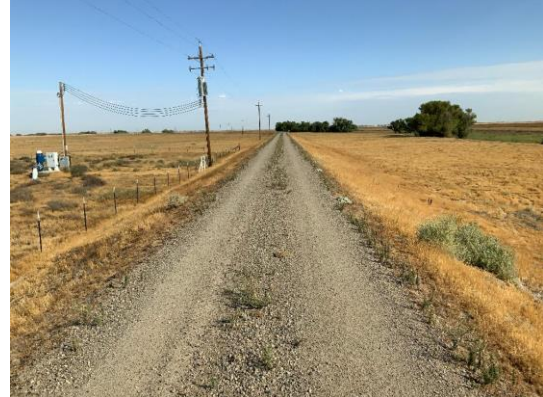
Photo 1 of 3 : UCIP_FA_2022_71112_103109.jpg

Comment Code						
Inspector Comment						
DS_ID:19866 FS_ID:71112 EP_NO: N/A Repair Type: Non-Urgent EVAL Issue: Crossing Status: Found UCIP Comments: 07/27/2021 The record has been upgraded from No Action Needed to Non-Urgent. Crossing appears to be in good condition. No permit was found authorizing this encroachment. CVFPB will need to review crossing to determine owner. The UCIP inspection was completed with GEI staff, P. Espinoza. (H. Dunn – GEI) FIELD_STRUCT_DESC: 24-inch corrugated metal gravity drainage pipe (CMP) through the levee, 7.0 feet below the crown. Slide gate in a 36-inch CMP riser unit on the waterside (WS) slope. Concrete headwall on the landside (LS) end. Concrete saddle and apron on the WS end. [Additional Reference(s): DWR Levee Log, 2002, (HLM 6.78). USACE San Joaquin O&M Manual, Unit No. 601, Part No. 1, 1967, Amended in 1978, Revised 20 June 1985, (HLM 6.79). DWR As-Built Specification No. 61-01, Sheet No. 50, 7 March 1961, (HLM 6.79)]. FS Date: 7/27/2021

Levee crown.

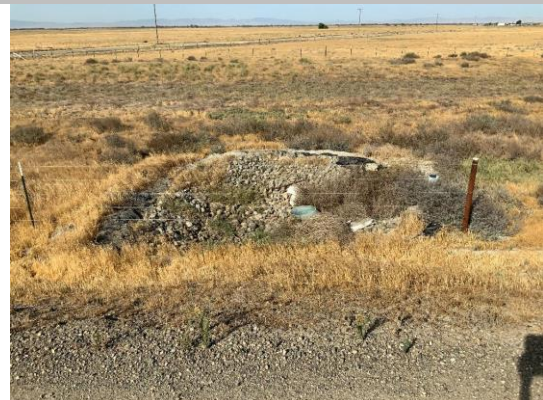
Photo 2 of 3 : UCIP_FA_2022_71112_103106.jpg

LS view: Toe from crown.

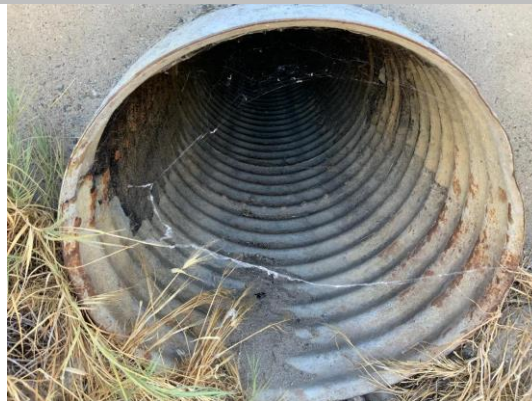
Photo 3 of 3 : UCIP_FA_2022_71112_103107.jpg

LS view: Closeup of pipe inlet at toe.

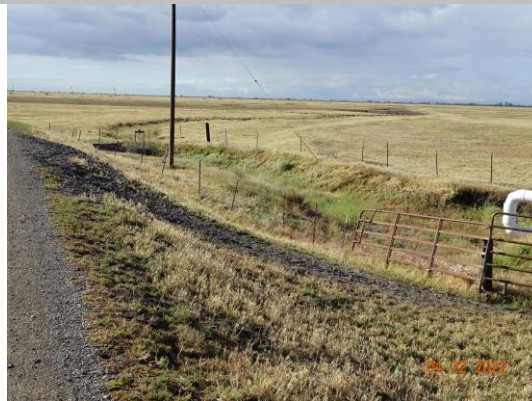
Photo 1 of 1 : FA_2022_NA0010_124_143_20220822_00057.jpg

LM Start	6.88	Rating **	M	Issue No.	143
LM End	6.88	Issue Type +	Ma	Location *	LS
Category	Earthen Levee			GPS Latitude/Longitude	
				Start	End
Item	Erosion / Livestock			37.228370 °	37.228370 °
				-120.728004 °	-120.728004 °
DWR ID	DWR_NA0010_06_s_2022_143				
Comment Code					
E4 : Repair the levee slope damaged by livestock and prevent large animal access.					
Inspector Comment

Levee damage on the landside slope from livestock activity. (Spring 2022)

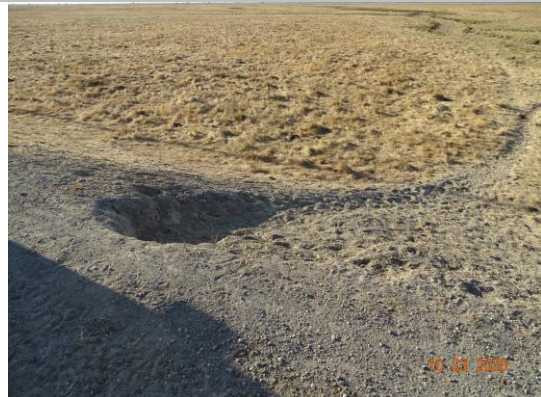
Photo 1 of 1 : FA_2022_NA0010_124_79_20220822_00015.jpg

LM Start	6.92	Rating **	M	Issue No.	79
LM End	6.92	Issue Type +	Ma	Location *	LS
Category	Earthen Levee			GPS Latitude/Longitude	
				Start	End
Item	Erosion / Livestock			37.228054 °	37.228054 °
				-120.727428 °	-120.727428 °
DWR ID	DWR_NA0010_06_f _ 2018_79				
Comment Code					
E4 : Repair the levee slope damaged by livestock and prevent large animal access.					
Inspector Comment					
Slope damage has been repaired with loose soil.

View down the landside slope of damage from livestock. (Fall 2020)

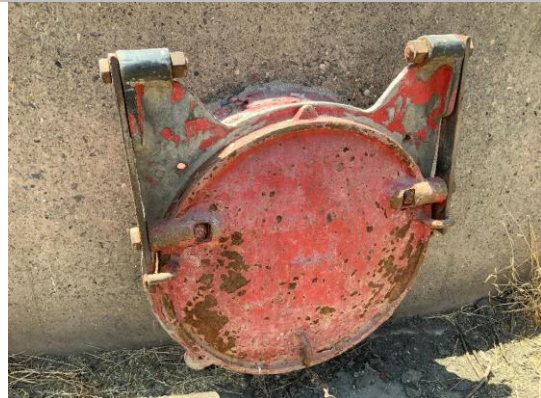
Photo 2 of 2 : UCIP_FA_2022_71114_101637.jpg

WS view: Closeup of flapgate at toe.

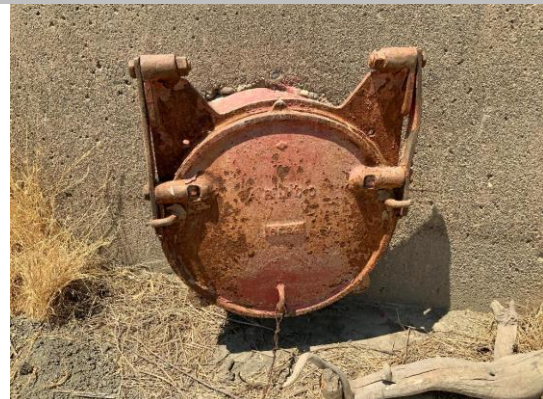
Photo 2 of 2 : UCIP_FA_2022_71115_101642.jpg

WS view: Closeup of flapgate at toe.

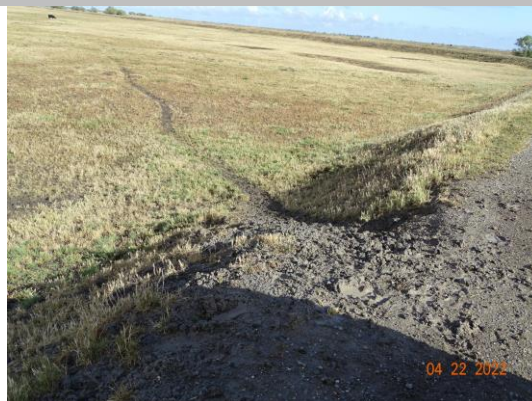
Photo 1 of 1 : FA_2022_NA0010_124_74_20220822_00012.jpg

LM Start	7.66	Rating **	M	Issue No.	74
LM End	7.66	Issue Type +	Ma	Location *	LS
Category	Earthen Levee			GPS Latitude/Longitude	
				Start	End
Item	Erosion / Livestock			37.222689 °	37.222689 °
				-120.716400 °	-120.716400 °
DWR ID	DWR_NA0010_06_f _ 2018_74				
Comment Code					
E4 : Repair the levee slope damaged by livestock and prevent large animal access.					
Inspector Comment					
Damage to levee slope from livestock access.

Slope damage from livestock. (Spring 2022)

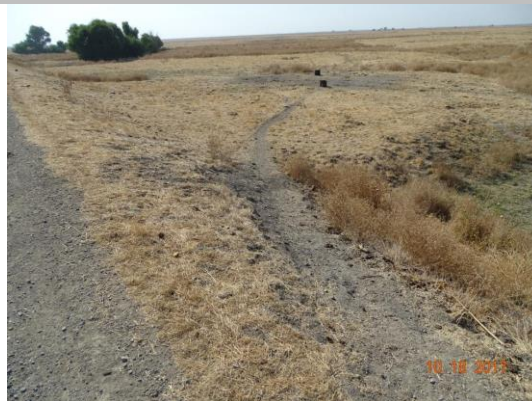
Photo 1 of 1 : FA_2022_NA0010_124_65_20220822_00005.jpg

LM Start	8.08	Rating **	A/W	Issue No.	65
LM End	8.08	Issue Type +	Ma	Location *	LS
Category	Earthen Levee			GPS Latitude/Longitude	
				Start	End
Item	Erosion / Livestock			37.217199 °	37.217199 °
				-120.713374 °	-120.713374 °
DWR ID	DWR_NA0010_06_f_2017_65				
Comment Code					
E4 : Repair the levee slope damaged by livestock and prevent large animal access.					
Inspector Comment					
Livestock damage to levee slope but the integrity of the levee is not compromised. Continue to monitor.

Looking southwest at the landside slope.

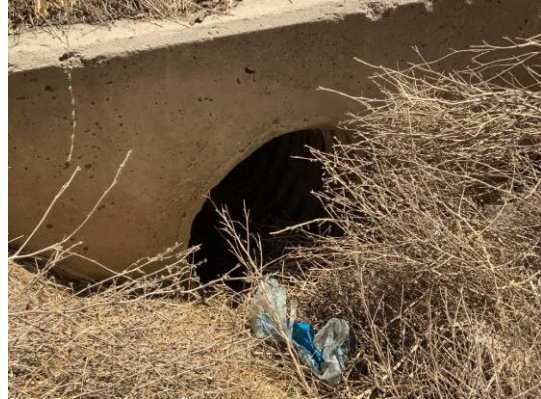
Photo 1 of 2 : UCIP_FA_2022_71116_102250.jpg

DS_ID:19870
FS_ID:71116
EP_NO: N/A
Repair Type: Non-Urgent
EVAL Issue: 5, Pipe Damage
Crossing Status: Found
UCIP Comments: 07/13/2021 Record remains Non-Urgent. DWR DMP internal inspection has found pipe integrity issues. LOF of crossing is greater than or equal to 4.1 and less than 5. Crossing will be monitored until funding becomes available for rehabilitation. Some vegetation buildup over LS pipe inlet and WS flapgate, recommend removal of vegetation on both ends. No permit was found authorizing this encroachment. CVFPB will need to review crossing to determine owner. The UCIP inspection was completed with GEI staff, P. Espinoza. (H. Dunn – GEI) 04/18/2014 Sediment buildup in pipe--recommend contacting owner to clear sediment. (O. Magana - DWR UCIP)
FIELD_STRUCT_DESC: 24-inch corrugated metal gravity drainage pipe (CMP) through the levee, 16.5 feet below the crown. Flap gate on the waterside (WS) end. Concrete headwall on each end. [Additional Reference(s): DWR Levee Log, 2002, (HLM 8.22). USACE San Joaquin O&M Manual, Unit No. 601, Part No. 1, 1967, Amended in 1978, Revised 20 June 1985, (HLM 8.21). DWR As-Built Specification No. 61-01, Sheet No. 51, 7 March 1961, (HLM 8.21)].

LS view: Closeup of pipe inlet at toe. Some vegetation blocking.

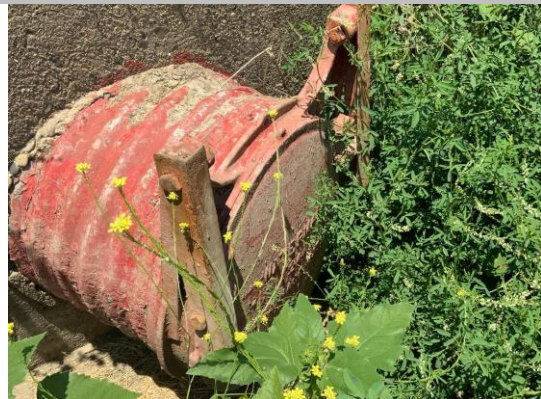
Photo 2 of 2 : UCIP_FA_2022_71116_102246.jpg

WS view: Closeup of flapgate at toe.

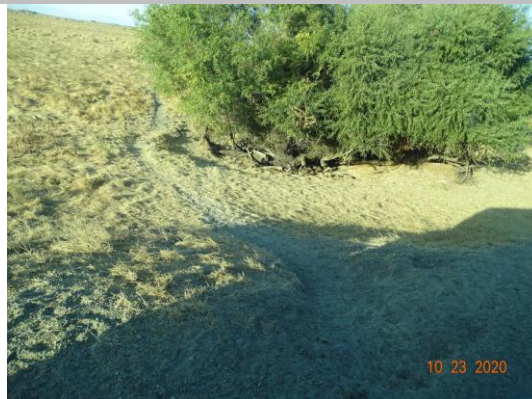
Photo 1 of 1 : FA_2022_NA0010_124_104_20220822_00031.jpg

LM Start	8.20	Rating **	A/W	Issue No.	104
LM End	8.20	Issue Type +	Ma	Location *	LS
Category	Earthen Levee			GPS Latitude/Longitude	
				Start	End
Item	Erosion / Livestock			37.215588 °	37.215588 °
				-120.712406 °	-120.712406 °
DWR ID	DWR_NA0010_06_f_2020_104				
Comment Code					
E4 : Repair the levee slope damaged by livestock and prevent large animal access.					
Inspector Comment					
Slope damage on both sides has been repaired with loose soil. Monitor for settlement.

Livestock damage to the landside slope. (Fall 2020)

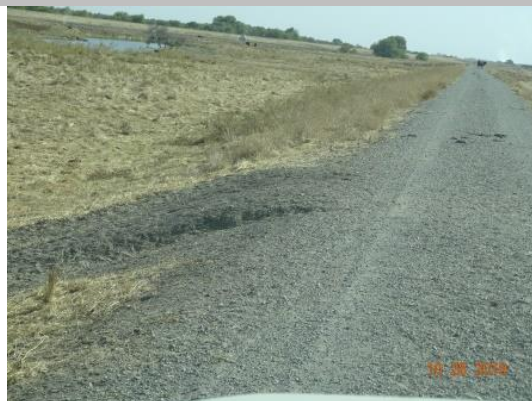
Photo 1 of 1 : FA_2022_NA0010_124_89_20220822_00022.jpg

LM Start	8.32	Rating **	A/W	Issue No.	89
LM End	8.32	Issue Type +	Ma	Location *	WS
Category	Earthen Levee			GPS Latitude/Longitude	
				Start	End
Item	Erosion / Livestock			37.214273 °	37.214273 °
				-120.711100 °	-120.711100 °
DWR ID	DWR_NA0010_06_f _ 2019_89				
Comment Code					
E4 : Repair the levee slope damaged by livestock and prevent large animal access.					
Inspector Comment					
Slope damage has been repaired with loose soil. Monitor for settlement.

View of damage to the waterside slope looking upstream. (Fall 2019)

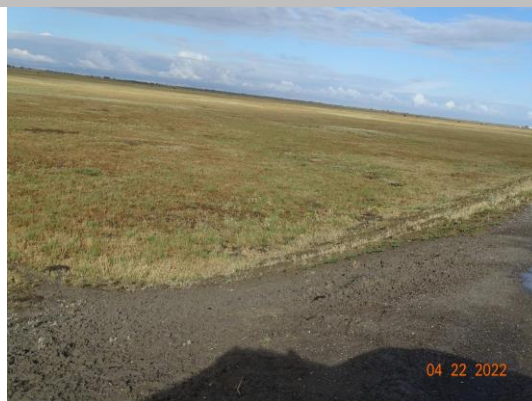
Photo 1 of 1 : FA_2022_NA0010_124_142_20220822_00056.jpg

LM Start	8.33	Rating **	A/W	Issue No.	142
LM End	8.33	Issue Type +	Ma	Location *	LS
Category	Earthen Levee			GPS Latitude/Longitude	
				Start	End
Item	Erosion / Livestock			37.214232 °	37.214232 °
				-120.711025 °	-120.711025 °
DWR ID	DWR_NA0010_06_s_2022_142				
Comment Code					
E4 : Repair the levee slope damaged by livestock and prevent large animal access.					
Inspector Comment

Looking down the levee slope at livestock damage. (Spring 2022)

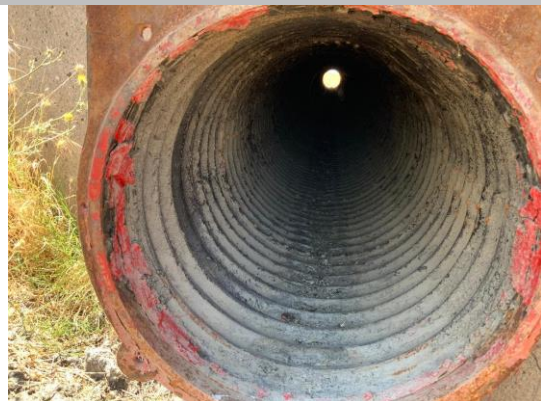
Photo 2 of 2 : UCIP_FA_2022_71117_102253.jpg

WS view: Inside pipe outlet at toe.

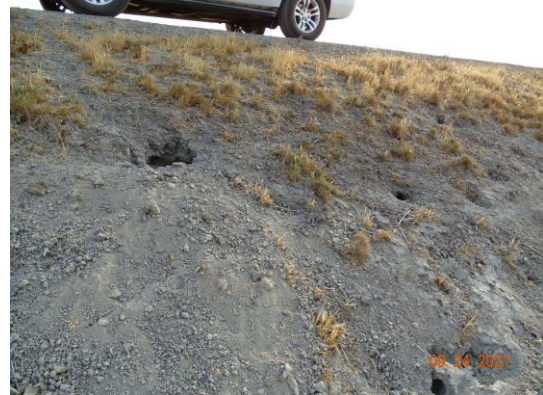
Photo 1 of 1 : FA_2022_NA0010_124_121_20220822_00042.jpg

LM Start	8.61	Rating **	M	Issue No.	121
LM End	8.69	Issue Type +	Ma	Location *	LS
Category	Earthen Levee			GPS Latitude/Longitude	
				Start	End
Item	Animal Control			37.211700 °	37.210809 °
				-120.706976 °	-120.706106 °
DWR ID	DWR_NA0010_06_f_2021_121				
Comment Code					
A1 : Exterminate rodents and backfill and compact or grout burrows.					
Inspector Comment

Looking at rodent holes in the landside slope. (Fall 2021)

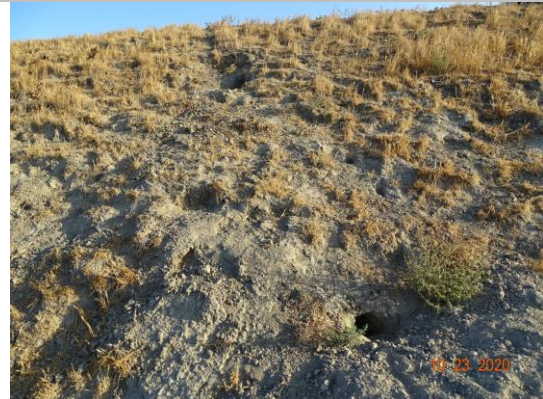
Photo 1 of 1 : FA_2022_NA0010_124_103_20220822_00030.jpg

LM Start	9.67	Rating **	M	Issue No.	103
LM End	9.71	Issue Type +	Ma	Location *	LS
Category	Earthen Levee			GPS Latitude/Longitude	
				Start	End
Item	Animal Control			37.200934 °	37.200836 °
				-120.694084 °	-120.693406 °
DWR ID	DWR_NA0010_06_f_2020_103				
Comment Code					
A3 : No rodents visible, but rodent burrows visible; need to backfill and compact or grout burrows.					
Inspector Comment

Rodent holes in the landside slope. (Fall 2020)

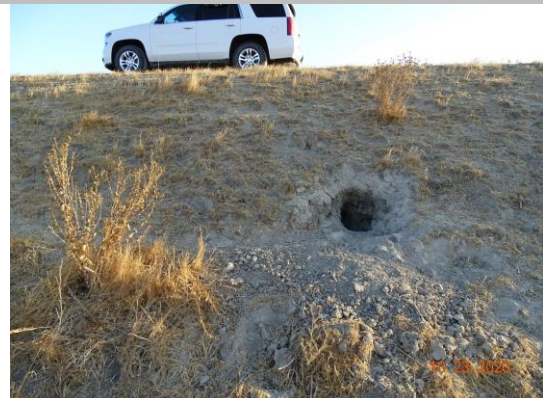
Photo 1 of 1 : FA_2022_NA0010_124_102_20220822_00029.jpg

LM Start	10.12	Rating **	U	Issue No.	102
LM End	10.12	Issue Type +	Ma	Location *	LS
Category	Earthen Levee			GPS Latitude/Longitude	
				Start	End
Item	Animal Control			37.196845 °	37.196845 °
				-120.687892 °	-120.687892 °
DWR ID	DWR_NA0010_06_f_2020_102				
Comment Code					
A3 : No rodents visible, but rodent burrows visible; need to backfill and compact or grout burrows.					
Inspector Comment

View of large animal burrow in the landside slope. (Fall 2020)

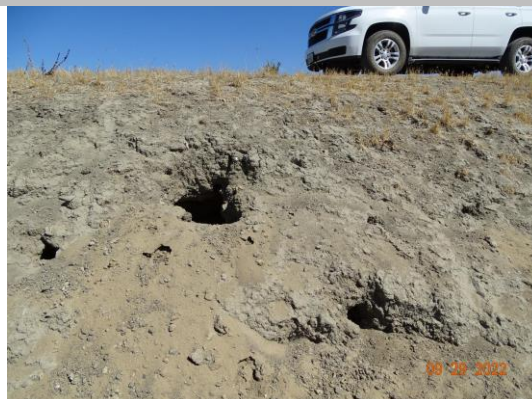
Photo 1 of 1 : FA_2022_NA0010_124_156_20221010_00247.jpg

LM Start	10.78	Rating **	U	Issue No.	156
LM End	10.78	Issue Type +	Ma	Location *	LS
Category	Earthen Levee			GPS Latitude/Longitude	
				Start	End
Item	Animal Control			37.189849 °	37.189849 °
				-120.679749 °	-120.679749 °
DWR ID	DWR_NA0010_06_f_2022_156				
Comment Code					
A3 : No rodents visible, but rodent burrows visible; need to backfill and compact or grout burrows.					
Inspector Comment					
Several rodent holes in the landside slope and landside access ramp.

Representative view of animal burrows on the landside slope. (Fall 2022)

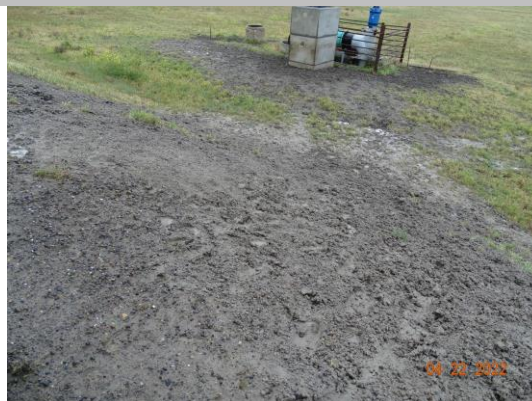
Photo 1 of 1 : FA_2022_NA0010_124_141_20220822_00055.jpg

LM Start	10.96	Rating **	A/W	Issue No.	141
LM End	10.96	Issue Type +	Ma	Location *	LS
Category	Earthen Levee			GPS Latitude/Longitude	
				Start	End
Item	Erosion / Livestock			37.187999 °	37.187999 °
				-120.677522 °	-120.677522 °
DWR ID	DWR_NA0010_06_s_2022_141				
Comment Code					
E4 : Repair the levee slope damaged by livestock and prevent large animal access.					
Inspector Comment

View of damage to the landside slope. (Spring 2022)

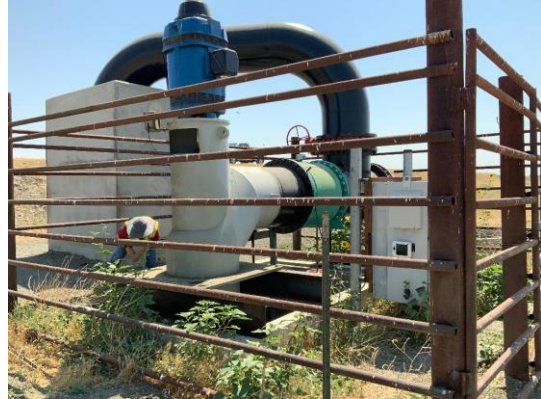
Photo 1 of 1 : UCIP_FA_2022_71128_102319.jpg

Comment Code					
Inspector Comment					
DS_ID:19563 FS_ID:71128 EP_NO: 18624 Repair Type: Non-Urgent EVAL Issue: 10, Unauthorized Modification or Non-Compliant Permit Crossing Status: Found UCIP Comments: 07/13/2021 The record has been upgraded from No Action Needed to Non-Urgent. WS outlets were underwater at time of inspection, limited inspection. There appears to be a new pump and pipe system off the LS toe. Confirm with owner on the status of this crossing. The UCIP inspection was completed with GEI staff, P. Espinoza. (H. Dunn – GEI) FIELD_STRUCT_DESC: 36-inch reinforced concrete water supply pipe (RCP) through the levee, 5.0 feet below the crown. Pipe riser units on both the inlet and the outlet sides. Control gate on the landside (LS). Slide gate on the waterside (WS) end. Joints secured in hoop steel and encased in concrete at each levee toe. (36-inch water pipe authorized under Permit No. 18624, 2010 - Wolfsen Land and Cattle Company). FS Date: 7/13/2021

LS view: New pump and pipe system off the toe.

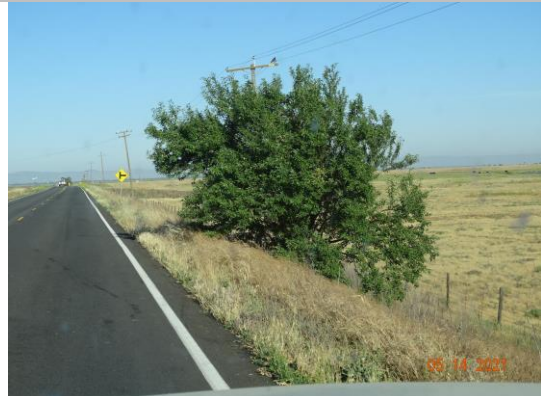
Photo 1 of 1 : FA_2022_NA0010_124_14_20220822_00003.jpg

LM Start	11.49	Rating **	M	Issue No.	14
LM End	11.49	Issue Type +	Ma	Location *	WS
Category	Earthen Levee			GPS Latitude/Longitude	
				Start	End
Item	Trim / Thin Trees			37.186189 °	37.186189 °
				-120.668476 °	-120.668476 °
DWR ID	DWR_NA0010_06_s_2015_14				
Comment Code					
T1 : Trim and thin trees to at least five feet above ground level to allow visibility of the ground and room to flood fight.					
Inspector Comment					
Almond tree located along Sandy Mush Road on waterside slope.

Looking west at tree on waterward slope. (Spring 2021)

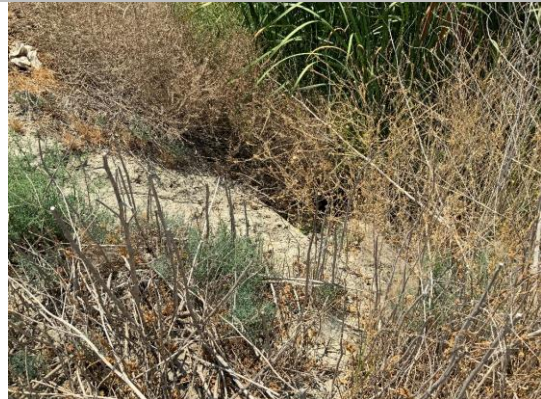
Photo 1 of 2 : UCIP_FA_2022_71150_102326.jpg

Comment Code					
Inspector Comment					
DS_ID:19875 FS_ID:71150 EP_NO: N/A Repair Type: Non-Urgent EVAL Issue: 11, Maintenance Compliance Issue Crossing Status: Indicator Found UCIP Comments: 07/13/2021 The record remains Non-Urgent. Limited inspection due to dense vegetation over both LS inlet/headwall and WS flapgate, recommend removal of vegetation on both ends. WS toe is also covered by barbed wire. No permit was found authorizing this encroachment. CVFPB will need to review crossing to determine owner. The UCIP inspection was completed with GEI staff, P. Espinoza. (H. Dunn – GEI) 04/17/2014 Unable to stop--high traffic area--safety issue. Crossing needs to be evaluated. (O. Magana - DWR UCIP) FIELD_STRUCT_DESC: 24-inch corrugated metal gravity drainage pipe (CMP) through the levee, 16.6 feet below the crown. Flap gate on the waterside (WS) end. [Additional Reference(s): DWR Levee Log, 2002, (HLM 11.65). USACE San Joaquin O&M Manual, Unit No. 601, Part No. 1, 1967, Amended in 1978, Revised 20 June 1985, (HLM 11.64). DWR As-Built Specification No. 59-01, Sheet No. 66, 10 December 1958, (HLM 11.64)]. FS Date: 7/13/2021

LS view: Top of headwall barely visible under dense vegetation.

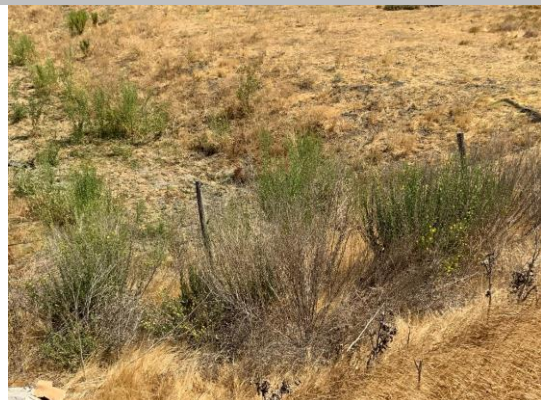
Photo 2 of 2 : UCIP_FA_2022_71150_102323.jpg

WS view: Lower slope, flapgate covered by barbed wire and dense vegetation.

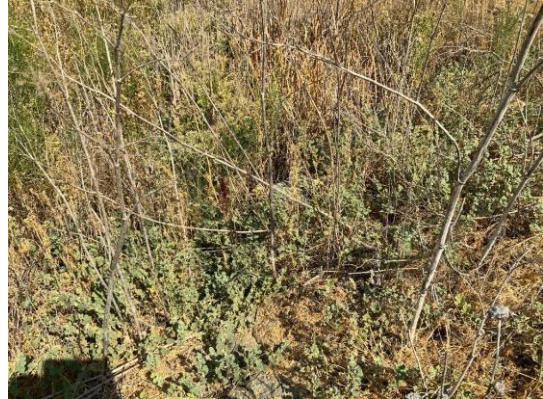
Photo 1 of 2 : UCIP_FA_2022_71151_102328.jpg

Comment Code					
Inspector Comment					
DS_ID:19876 FS_ID:71151 EP_NO: N/A Repair Type: Non-Urgent EVAL Issue: 11, Maintenance Compliance Issue Crossing Status: Found UCIP Comments: 07/13/2021 The record remains Non-Urgent. Dense vegetation over LS inlet and WS outlet, recommend removal of vegetation from both sides. Limited inspection of both inlet and outlet. No permit was found authorizing this encroachment. CVFPB will need to review crossing to determine owner. The UCIP inspection was completed with GEI staff, P. Espinoza. (H. Dunn – GEI) 04/17/2014 Clear debris from waterward and landward toes. (O. Magana - DWR UCIP) FIELD_STRUCT_DESC: 36-inch corrugated metal gravity drainage pipe (CMP) through the levee, 17.0 feet below the crown. Slide gate in a pipe riser unit on the waterside (WS) slope. [Additional Reference(s): DWR Levee Log, 2002, (HLM 11.83). USACE San Joaquin O&M Manual, Unit No. 601, Part No. 1, 1967, Amended in 1978, Revised 20 June 1985, (HLM 11.82). DWR As-Built Specification No. 59-01, Sheet No. 66, 10 December 1958, (HLM 11.82)]. FS Date: 7/13/2021

WS view: Flapgate barely visible under dense vegetation at toe.

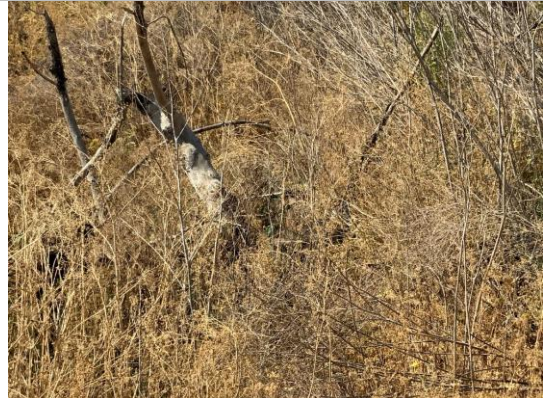
Photo 2 of 2 : UCIP_FA_2022_71151_102333.jpg

LS view: Headwall and inlet covered by dense vegetation at toe.

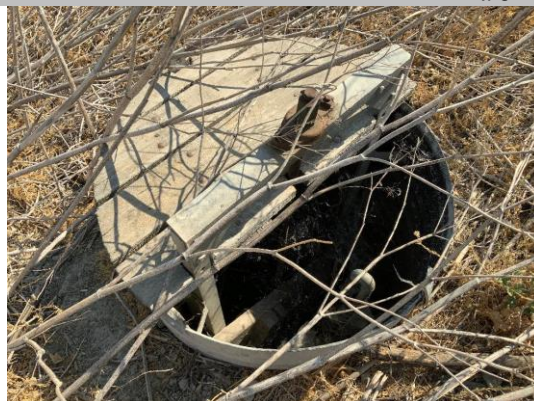
Photo 2 of 3 : UCIP_FA_2022_71152_102337.jpg

Comment Code						
Inspector Comment						
DS_ID:19877 FS_ID:71152 EP_NO: N/A Repair Type: Non-Urgent EVAL Issue: 4b, Safety Issue Crossing Status: Found UCIP Comments: 07/13/2021 The record remains Non-Urgent. Partial cover on WS riser, recommend repair for safety reasons. Limited inspection due to LS pipe inlet being overed with vegetation, headwall barely visible, recommend removal. WS outlet not found, possibly buried under dirt or vegetaion. Recommend removal of vegetation and dirt to uncover WS pipe outlet. No permit was found authorizing this encroachment. CVFPB will need to review crossing to determine owner. The UCIP inspection was completed with GEI staff, P. Espinoza. (H. Dunn – GEI) 04/17/2014 Not accessible--crossing is buried on landward side. Need to contact owner to determine status. (O. Magana - DWR UCIP) FIELD_STRUCT_DESC: 24-inch corrugated metal gravity drainage pipe (CMP) through the levee, 10.8 feet below the crown. Flap gate on the waterside (WS) end. [Additional Reference(s): DWR Levee Log, 2002, (HLM 13.31). USACE San Joaquin O&M Manual, Unit No. 601, Part No. 1, 1967, Amended in 1978, Revised 20 June 1985, (HLM 13.30). DWR As-Built Specification No. 59-01, Sheet No. 67, 10 December 1958, (HLM 13.30)]. FS Date: 7/13/2021

WS view: Closeup of riser on slope, broken lid.

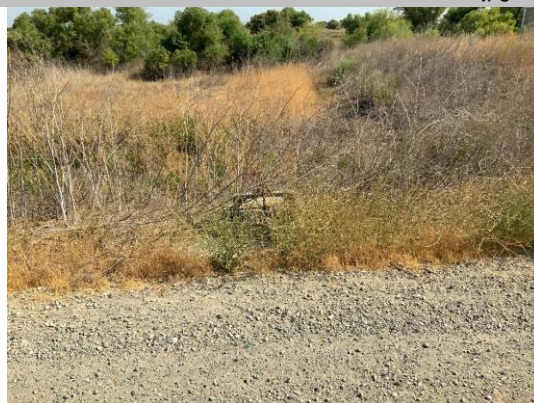
Photo 3 of 3 : UCIP_FA_2022_71152_102336.jpg

WS view: Riser visible on slope from crown.

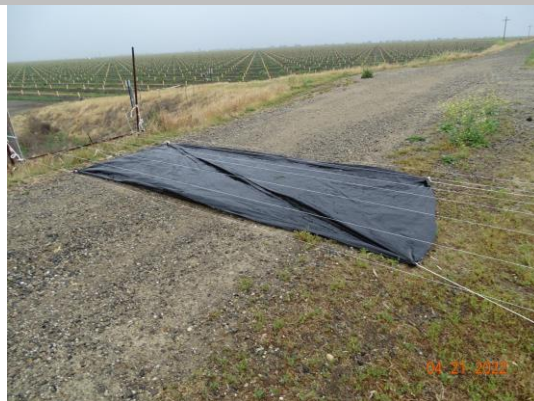
Photo 1 of 1 : FA_2022_NA0010_124_138_20220822_00054.jpg

LM Start	13.23	Rating **	M	Issue No.	138
LM End	13.23	Issue Type +	En	Location *	CR
Category	Earthen Levee			GPS Latitude/Longitude	
				Start	End
Item	Encroachments			37.171713 °	37.171713 °
				-120.654822 °	-120.654822 °
DWR ID	DWR_NA0010_06_s_2022_138				
Comment Code					
FE : Fence					
Inspector Comment					
Temporary livestock fence installed across the levee crown.

View of temporary fence installed across the levee crown. (Spring 2022)

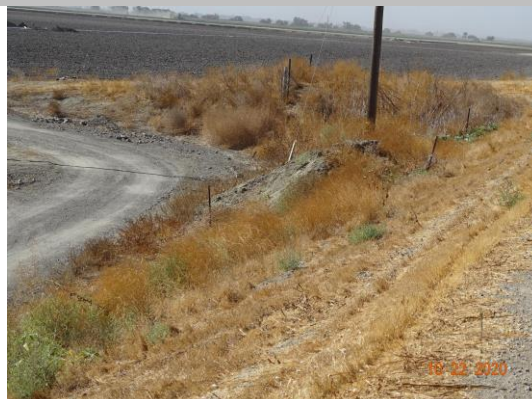
Photo 1 of 1 : FA_2022_NA0010_124_68_20220822_00008.jpg

LM Start	13.24	Rating **	M	Issue No.	68
LM End	13.24	Issue Type +	En	Location *	LS
Category	Earthen Levee			GPS Latitude/Longitude	
				Start	End
Item	Encroachments			37.171686 °	37.171686 °
				-120.654562 °	-120.654562 °
DWR ID	DWR_NA0010_06_f_2015_68				
Comment Code					
MA : Material					
Inspector Comment					
Landowner stockpiled dirt at landside toe.

Looking downstream at dirt stockpile on the landside toe. (Fall 2020)

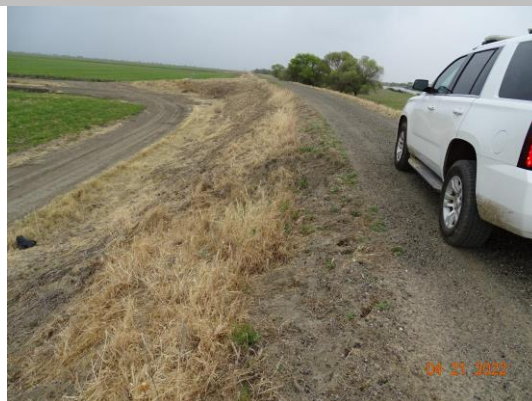
Photo 1 of 1 : FA_2022_NA0010_124_120_20220822_00041.jpg

LM Start	14.00	Rating **	U	Issue No.	120
LM End	14.00	Issue Type +	Ma	Location *	LS
Category	Earthen Levee			GPS Latitude/Longitude	
				Start	End
Item	Slope Stability			37.171591 °	37.171591 °
				-120.640938 °	-120.640938 °
DWR ID	DWR_NA0010_06_f_2021_120				
Comment Code					
S1 : Repair slope instability.					
Inspector Comment					
Caving has eaten approximately 1 foot into the levee crown.

View of slope stability issue on the landside slope. (Spring 2022)

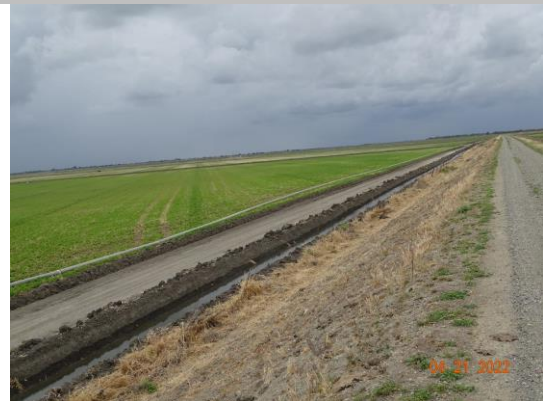
Photo 1 of 1 : FA_2022_NA0010_124_119_20220822_00040.jpg

LM Start	14.71	Rating **	M	Issue No.	119
LM End	15.23	Issue Type +	En	Location *	LS
Category	Earthen Levee			GPS Latitude/Longitude	
				Start	End
Item	Encroachments			37.164000 °	37.160390 °
				-120.632225 °	-120.623995 °
DWR ID	DWR_NA0010_06_f_2021_119				
Comment Code					
DT : Ditch					
Inspector Comment					
Ditch dug approximate 5 - 15 feet from the landside toe.

Ditch landowner has dug on the landside toe. (Spring 2022)

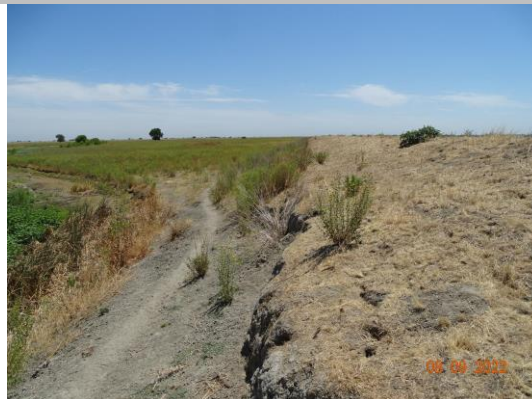
Photo 2 of 3 : SJR2022_NA0010U06LM14.95_1.JPG

LM Start	14.93	Rating **	U	Issue No.	154
LM End	14.97	Issue Type +	Ma	Location *	
Category	Supplemental			GPS Latitude/Longitude	
				Start	End
Item	DWR Erosion Survey			37.162200 °	37.162200 °
				-120.628600 °	-120.628600 °
DWR ID	NA0010U06RM11.7				
Comment Code					
Inspector Comment					
Site ID: NA0010U06RM11.7 08/09/2022: The site was discovered by the LMA and visited during the annual field survey. The erosion is into the levee prism with a 5-ft vertical scarp running along the lower levee slope. There is a 12-15 ft wide berm below the erosion.

8/9/2022: Close-up view of the erosion scarp.

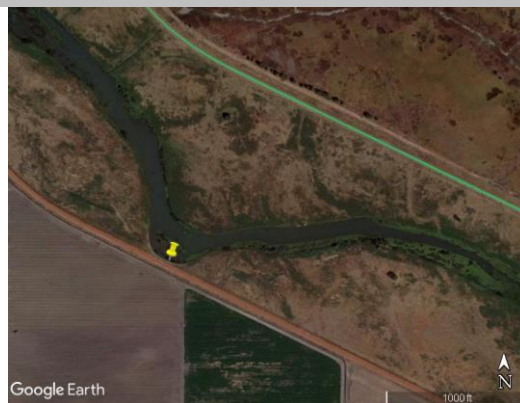
Photo 3 of 3 : SJR2022_NA0010U06LM14.95_GE.JPG

9/13/2022: Aerial view of the erosion site (Google Earth Imagery from 9/25/2020).

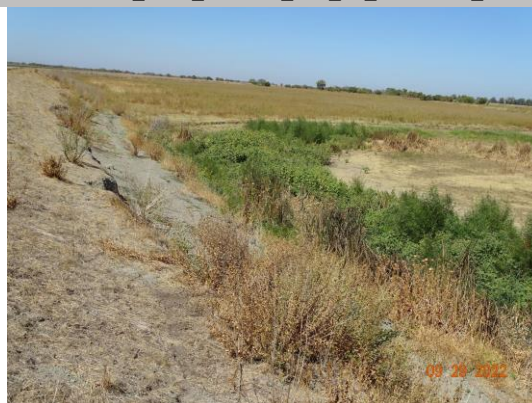
Photo 1 of 1 : FA_2022_NA0010_124_88_20221010_00248.jpg

LM Start	14.95	Rating **	U	Issue No.	88
LM End	14.99	Issue Type +	Ma	Location *	WS
Category	Earthen Levee			GPS Latitude/Longitude	
				Start	End
Item	Erosion / Bank Caving			37.162215 °	37.161921 °
				-120.628664 °	-120.627923 °
DWR ID	DWR_NA0010_06_f_2022_88				
Comment Code					
E2 : Schedule repair of erosion site prior to the next inspection.					
Inspector Comment					
Erosion is approximately 200 feet long, 15 feet in height and within the theoretical prism.

Erosion into the waterside toe. (Fall 2022)

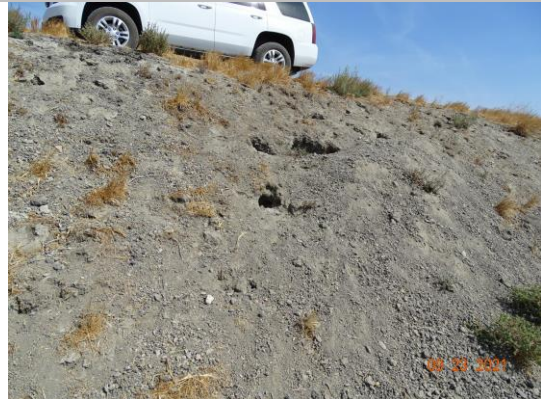
Photo 1 of 1 : FA_2022_NA0010_124_124_20220822_00044.jpg

LM Start	15.28	Rating **	U	Issue No.	124
LM End	15.61	Issue Type +	Ma	Location *	LS
Category	Earthen Levee			GPS Latitude/Longitude	
				Start	End
Item	Animal Control			37.160104 °	37.157640 °
				-120.623317 °	-120.618180 °
DWR ID	DWR_NA0010_06_s_2012_124				
Comment Code					
A1 : Exterminate rodents and backfill and compact or grout burrows.					
Inspector Comment

Large rodent burrows observed in the landside slope. (Fall 2021)

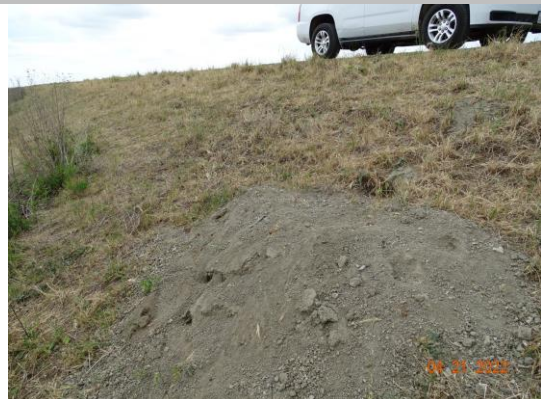
Photo 1 of 1 : FA_2022_NA0010_124_118_20220822_00039.jpg

LM Start	15.32	Rating **	M	Issue No.	118
LM End	15.32	Issue Type +	Ma	Location *	WS
Category	Earthen Levee			GPS Latitude/Longitude	
				Start	End
Item	Animal Control			37.159815 °	37.159815 °
				-120.622513 °	-120.622513 °
DWR ID	DWR_NA0010_06_s_2022_118				
Comment Code					
A1 : Exterminate rodents and backfill and compact or grout burrows.					
Inspector Comment

View of rodent holes on the waterside slope. (Spring 2022)

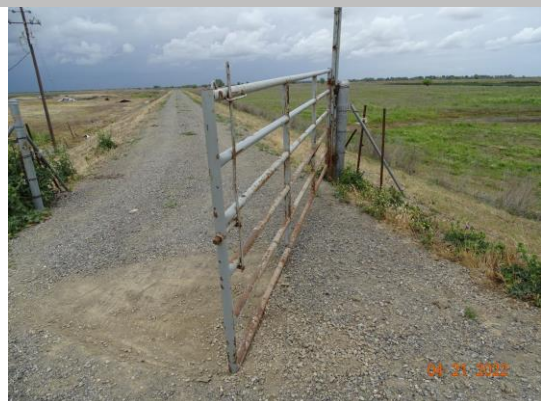
Photo 1 of 1 : FA_2022_NA0010_124_137_20220822_00053.jpg

LM Start	15.66	Rating **	M	Issue No.	137
LM End	15.66	Issue Type +	Ma	Location *	CR
Category	Earthen Levee			GPS Latitude/Longitude	
				Start	End
Item	Access Gates			37.157108 °	37.157108 °
				-120.617451 °	-120.617451 °
DWR ID	DWR_NA0010_06_s_2022_137				
Comment Code					
AG : Access Gates					
Inspector Comment					
New gate installed does not have enough clearance above the levee crown to fully open. This a possible access issue for larger vehicles. Recommend reinstalling or replacing.

View of access gate that cannot fully open and is damaging the levee crown. (Spring 2022)

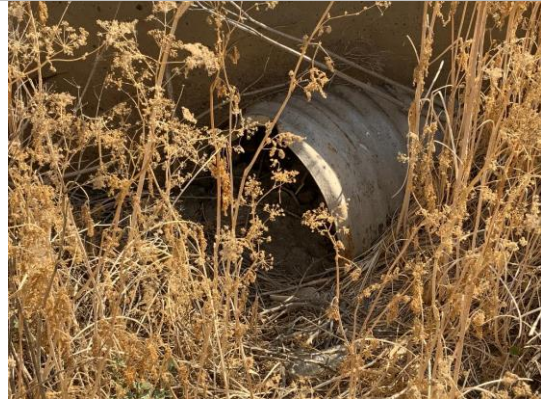
Photo 1 of 2 : UCIP_FA_2022_71133_102351.jpg

Comment Code					
Inspector Comment					
DS_ID:19884 FS_ID:71133 EP_NO: N/A Repair Type: Non-Urgent EVAL Issue: 11, Maintenance Compliance Issue Crossing Status: Found UCIP Comments: 07/13/2021 The record remains Non-Urgent. Limited inspection of LS pipe inlet. LS pipe edges are warped and inlet filled with sediment and some vegetation, recommend cleaning out. No permit was found authorizing this encroachment. CVFPB will need to review crossing to determine owner. The UCIP inspection was completed with GEI staff, P. Espinoza. (H. Dunn – GEI) 04/17/2014 Need to contact owner. Sediment buildup on both the waterward and landward side. Recommend removing sediment buildup from both side. Also recommend clearing excess sediment inside crossing. (O. Magana - DWR UCIP) FIELD_STRUCT_DESC: 24-inch corrugated metal gravity drainage pipe (CMP) through the levee, 14.0 feet below the crown. Flap gate on the waterside (WS) end. [Additional Reference(s): DWR Levee Log, 2002, (HLM 15.78). USACE San Joaquin O&M Manual, Unit No. 601, Part No. 1, 1967, Amended in 1978, Revised 20 June 1985, (HLM 15.76). DWR As-Built Specification No. 59-01, Sheet No. 69, 10 December 1958, (HLM 15.76)]. FS Date: 7/13/2021

LS view: Closeup of pipe inlet at toe with sediment buildup.

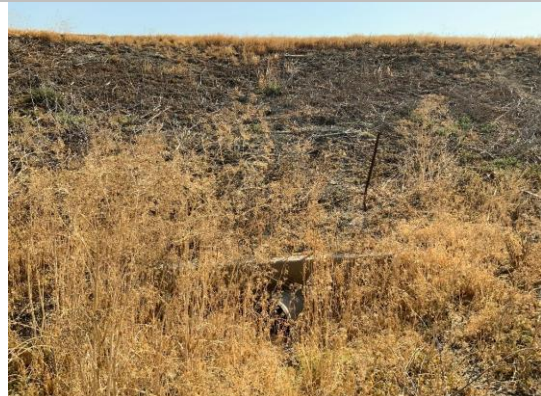
Photo 2 of 2 : UCIP_FA_2022_71133_102350.jpg

LS view: Headwall visible at toe.

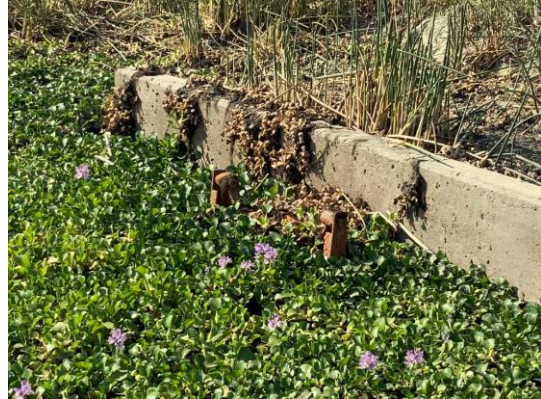
Photo 1 of 1 : UCIP_FA_2022_71134_102360.jpg

Comment Code						
Inspector Comment						
DS_ID:19885 FS_ID:71134 EP_NO: N/A Repair Type: Non-Urgent EVAL Issue: 11, Maintenance Compliance Issue Crossing Status: Found UCIP Comments: 07/13/2021 The record remains Non-Urgent. LS pipe inlet was underwater at time of inspection. WS flapgate was buried under sediment, limited inspection on both ends. Recommend removal of sediment covering flapgate on WS. No permit was found authorizing this encroachment. CVFPB will need to review crossing to determine owner. The UCIP inspection was completed with GEI staff, P. Espinoza. (H. Dunn – GEI) 04/17/2014 Need to contact owner to determine status of crossing. Waterward side is buried and not accessible. Landward side headwall is blocked by dense vegetation. Recommend confirming status of flap gate on waterward side and removing dense vegetation form landward side. (O. Magana - DWR UCIP) FIELD_STRUCT_DESC: 36-inch corrugated metal gravity drainage pipe (CMP) through the levee, 16.6 feet below the crown. Flap gate on the waterside (WS) end. [Additional Reference(s): DWR Levee Log, 2002, (HLM 15.93). USACE San Joaquin O&M Manual, Unit No. 601, Part No. 1, 1967, Amended in 1978, Revised 20 June 1985, (HLM 15.91). DWR As-Built Specification No. 59-01, Sheet No. 69, 10 December 1958, (HLM 15.91)]. FS Date: 7/13/2021

WS view: Closeup of headwall and flapgate covered by dirt at toe.

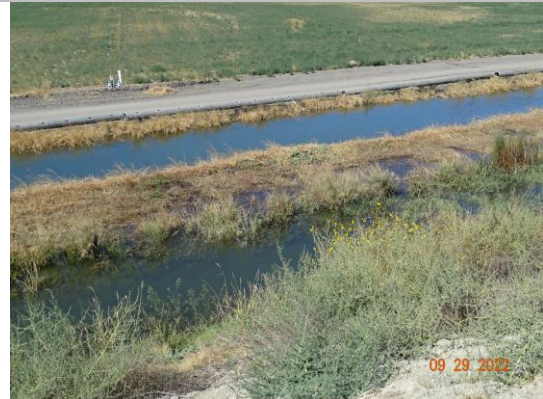
Photo 1 of 1 : FA_2022_NA0010_124_153_20221010_00249.jpg

LM Start	17.79	Rating **	M	Issue No.	153
LM End	18.77	Issue Type +	En	Location *	LS
Category	Earthen Levee			GPS Latitude/Longitude	
				Start	End
Item	Encroachments			37.133023 °	37.119876 °
				-120.593812 °	-120.587457 °
DWR ID	DWR_NA0010_06_f_2022_153				
Comment Code					
DT : Ditch					
Inspector Comment					
The ditch is located outside of the easement but water appears to be seeping through the ditch walls and causing water to pool on the landside toe.

Seepage on the landside toe from the nearby ditch. (Fall 2022)

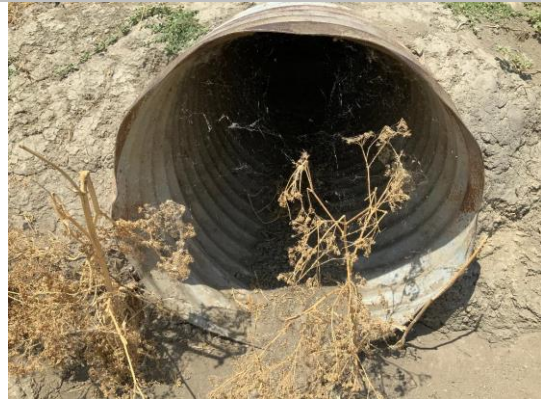
Photo 2 of 2 : UCIP_FA_2022_71139_101557.jpg

DS_ID:19889
 FS_ID:71139
 EP_NO: N/A
 Repair Type: Non-Urgent
 EVAL Issue: 4b, Safety Issue
 Crossing Status: Found
 UCIP Comments: 07/12/2021 The record remains Non-Urgent. Barbed wire over LS end, could not inspect closely. No cover over WS riser, causing safety hazard. Slightly warped edges on both WS and LS pipe inlet/outlet. No permit was found authorizing this encroachment. CVFPB will need to review crossing to determine owner. The UCIP inspection was completed with GEI staff, P. Espinoza. (H. Dunn – GEI)

WS view: Closeup of pipe outlet at toe with slightly warped edges.

04/17/2014 Dense vegetation limits the inspector's visibility to identify signs of pipe failure (leaks) along the landward slope. Recommend removing vegetation along pipe alignment to conduct proper inspection of structure. (O. Magana - DWR UCIP)

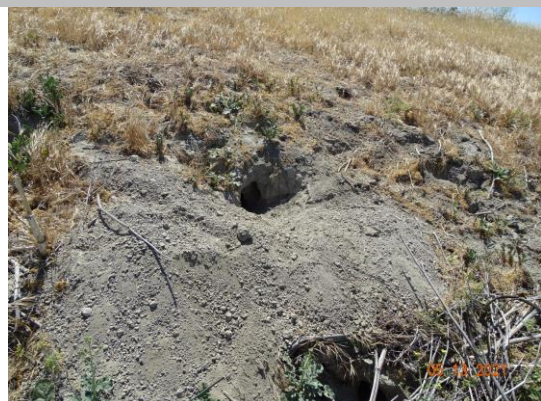
Photo 1 of 1 : FA_2022_NA0010_124_72_20220822_00011.jpg

LM Start	19.07	Rating **	U	Issue No.	72
LM End	19.07	Issue Type +	Ma	Location *	LS
Category	Earthen Levee			GPS Latitude/Longitude	
				Start	End
Item	Animal Control			37.115706 °	37.115706 °
				-120.587036 °	-120.587036 °
DWR ID	DWR_NA0010_06_s_2021_72				
Comment Code					
A1 : Exterminate rodents and backfill and compact or grout burrows.					
Inspector Comment

Large rodent burrows observed in the landside slope. (Spring 2021)

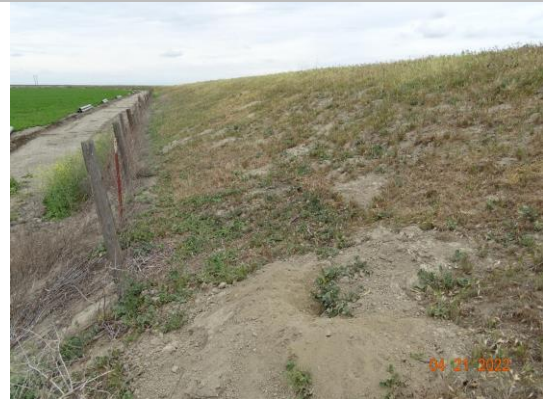
Photo 1 of 1 : FA_2022_NA0010_124_136_20220822_00052.jpg

LM Start	19.18	Rating **	M	Issue No.	136
LM End	19.22	Issue Type +	Ma	Location *	LS
Category	Earthen Levee			GPS Latitude/Longitude	
				Start	End
Item	Animal Control			37.114272 °	37.113716 °
				-120.587857 °	-120.588225 °
DWR ID	DWR_NA0010_06_s_2022_136				
Comment Code					
A3 : No rodents visible, but rodent burrows visible; need to backfill and compact or grout burrows.					
Inspector Comment

Looking downstream along the landside slope at rodent burrows. (Spring 2022)

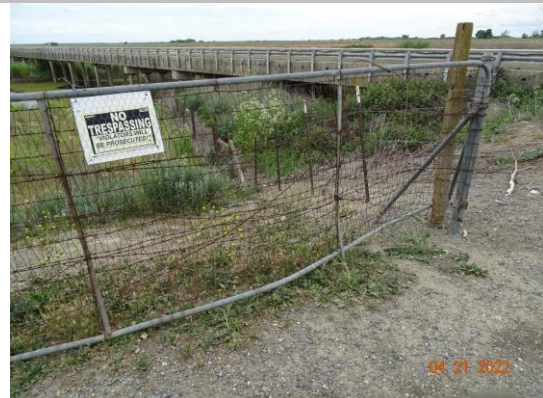
Photo 1 of 1 : FA_2022_NA0010_124_135_20220822_00051.jpg

LM Start	19.23	Rating **	M	Issue No.	135
LM End	19.23	Issue Type +	Ma	Location *	CR
Category	Earthen Levee			GPS Latitude/Longitude	
				Start	End
Item	Access Gates			37.113581 °	37.113581 °
				-120.588310 °	-120.588310 °
DWR ID	DWR_NA0010_06_s_2022_135				
Comment Code					
AG : Access Gates					
Inspector Comment					
Bottom of gate has broken off near hinge causing the gate to drag.

View of access gate with a broken bottom hinge. (Spring 2022)

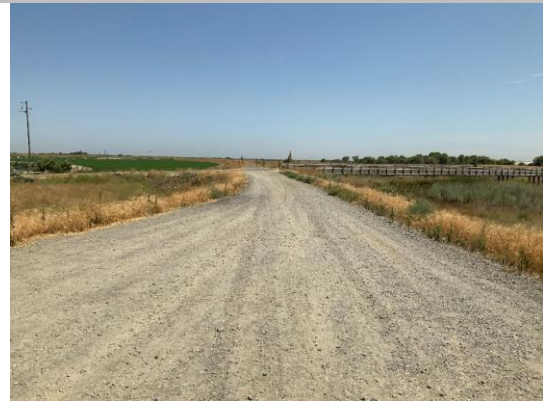
Photo 1 of 3 : UCIP_FA_2022_71140_101574.jpg

Comment Code						
Inspector Comment						
DS_ID:19890 FS_ID:71140 EP_NO: N/A Repair Type: Non-Urgent EVAL Issue: Crossing Status: Found UCIP Comments: 07/12/2021 The record remains Non-Urgent. WS pipe outlet visible but underwater, unable to inspect closely. LS pipe inlet was not seen, but likely underwater. No permit was found authorizing this encroachment. CVFPB will need to review crossing to determine owner. The UCIP inspection was completed with GEI staff, P. Espinoza. (H. Dunn – GEI) 04/17/2014 Dense vegetation limits the inspector's visibility to identify signs of pipe failure (leaks) along the slopes. Recommend removing vegetation along pipe alignment to conduct proper inspection of structure. (O. Magana - DWR UCIP) FIELD_STRUCT_DESC: 48-inch corrugated metal gravity drainage pipe (CMP) through the levee, 20.0 feet below the crown. Slide gate in a pipe riser unit on the waterside (WS) slope. Riprap along the landside (LS) slope. [Additional Reference(s): DWR Levee Log, 2002, (HLM 19.36). USACE San Joaquin O&M Manual, Unit No. 601, Part No. 1, 1967, Amended in 1978, Revised 20 June 1985, (HLM 19.36). DWR As-Built Specification No. 59-01, Sheet No. 72, 10 December 1958, (HLM 19.36)]. FS Date: 7/12/2021

Levee crown.

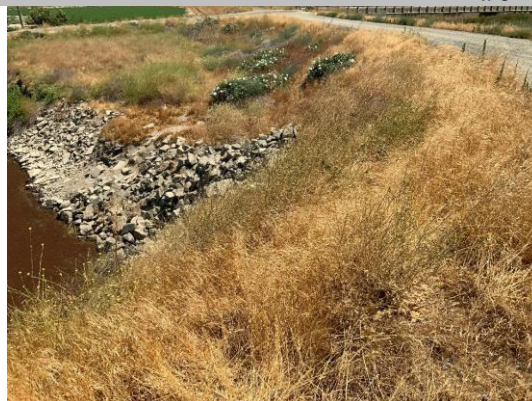
Photo 2 of 3 : UCIP_FA_2022_71140_101575.jpg

LS view: Slope from crown, no pipe visible.

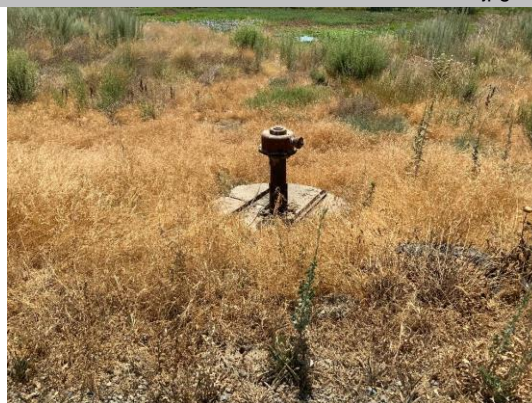
Photo 3 of 3 : UCIP_FA_2022_71140_101576.jpg

WS view: Slidegate visible on slope from crown.

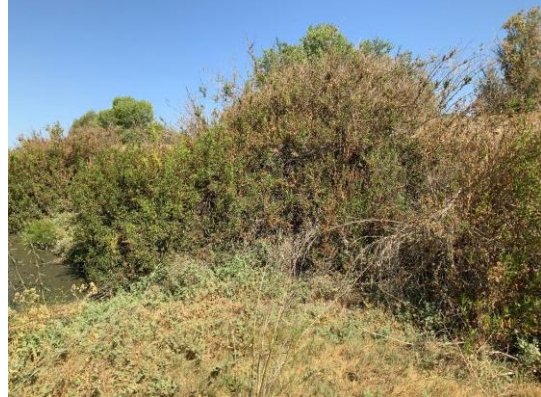
Photo 1 of 2 : UCIP_FA_2022_71141_101579.jpg

Comment Code						
Inspector Comment						
DS_ID:19891 FS_ID:71141 EP_NO: N/A Repair Type: Non-Urgent EVAL Issue: 11, Maintenance Compliance Issue Crossing Status: Found UCIP Comments: 07/12/2021 The record remains Non-Urgent. Limited inspection due to dense vegetation on LS and WS ends, LS headwall just barely visible, recommend removal of vegetation. No permit was found authorizing this encroachment. CVFPB will need to review crossing to determine owner. The UCIP inspection was completed with GEI staff, P. Espinoza. (H. Dunn – GEI) 04/17/2014 Dense vegetation limits the inspector's visibility to identify signs of pipe failure (leaks) along the slopes. Recommend removing vegetation along pipe alignment to conduct proper inspection of structure. (O. Magana - DWR UCIP) FIELD_STRUCT_DESC: 30-inch by 30-inch reinforced concrete box gravity drainage culvert (RCBC) through the levee, 14.0 feet below the crown. Flap gate on the waterside (WS) end. [Additional Reference(s): DWR Levee Log, 2002, (HLM 19.82). USACE San Joaquin O&M Manual, Unit No. 601, Part No. 1, 1967, Amended in 1978, Revised 20 June 1985, (HLM 19.85). DWR As-Built Specification No. 59-01, Sheet No. 73, 10 December 1958, (HLM 19.85)]. FS Date: 7/12/2021

LS view: Dense vegetation over pipe inlet at toe, pipe not visible.

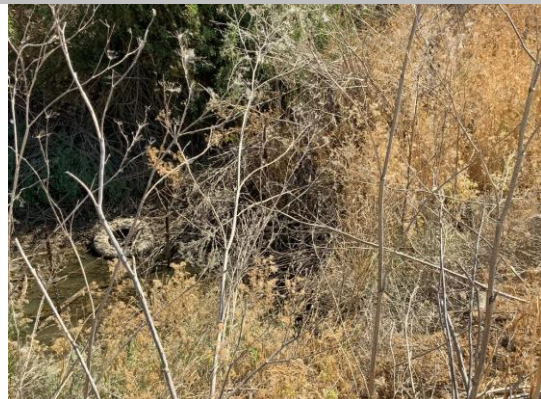
Photo 2 of 2 : UCIP_FA_2022_71141_101584.jpg

WS view: Close up of pipe outlet area covered with vegetation.

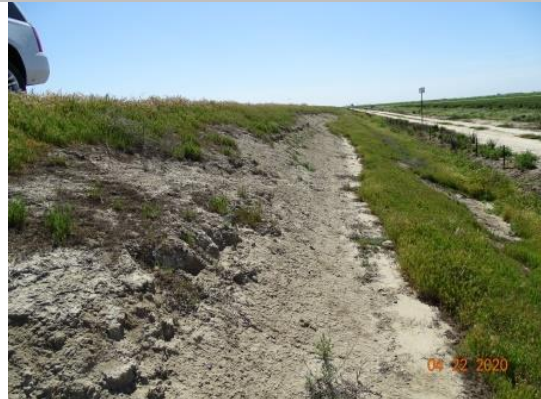
Photo 1 of 1 : FA_2022_NA0010_124_1209_20220822_00063.jpg

LM Start	20.79	Rating **	M	Issue No.	1209
LM End	21.19	Issue Type +	Ma	Location *	LS
Category	Earthen Levee			GPS Latitude/Longitude	
				Start	End
Item	Erosion / Livestock			37.113107 °	37.108653 °
				-120.563782 °	-120.558977 °
DWR ID	DWR_NA0010_06_s_2015_1209				
Comment Code					
E4 : Repair the levee slope damaged by livestock and prevent large animal access.					
Inspector Comment					
Erosion on landside slope greater than 3 inches. Erosion caused by livestock.

Erosion on the landside slope from livestock activity. (Spring 2020)

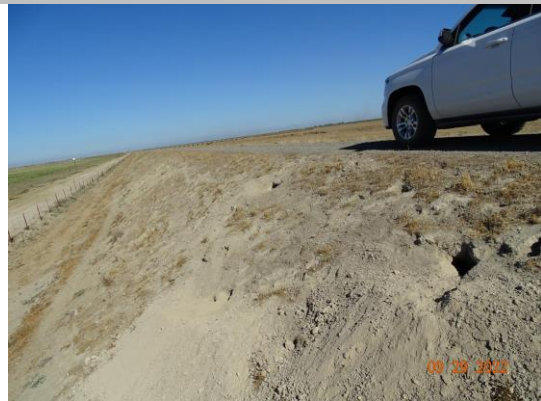
Photo 1 of 1 : FA_2022_NA0010_124_149_20221012_00250.jpg

LM Start	21.24	Rating **	M	Issue No.	149
LM End	21.24	Issue Type +	Ma	Location *	LS
Category	Earthen Levee			GPS Latitude/Longitude	
				Start	End
Item	Animal Control			37.108126 °	37.108126 °
				-120.558461 °	-120.558461 °
DWR ID	DWR_NA0010_06_f _ 2022_149				
Comment Code					
A1 : Exterminate rodents and backfill and compact or grout burrows.					
Inspector Comment

View of multiple rodent holes on the landside slope. (Fall 2022)

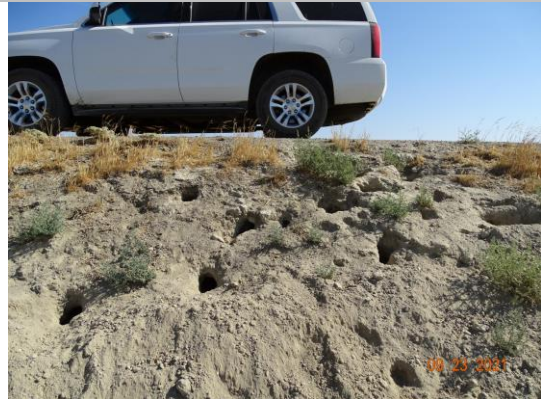
Photo 1 of 1 : FA_2022_NA0010_124_113_20220822_00035.jpg

LM Start	21.30	Rating **	U	Issue No.	113
LM End	21.30	Issue Type +	Ma	Location *	LS
Category	Earthen Levee			GPS Latitude/Longitude	
				Start	End
Item	Animal Control			37.107502 °	37.107502 °
				-120.557813 °	-120.557813 °
DWR ID	DWR_NA0010_06_f _ 2021_113				
Comment Code					
A3 : No rodents visible, but rodent burrows visible; need to backfill and compact or grout burrows.					
Inspector Comment

Several rodent holes observed at this location. (Fall 2021)

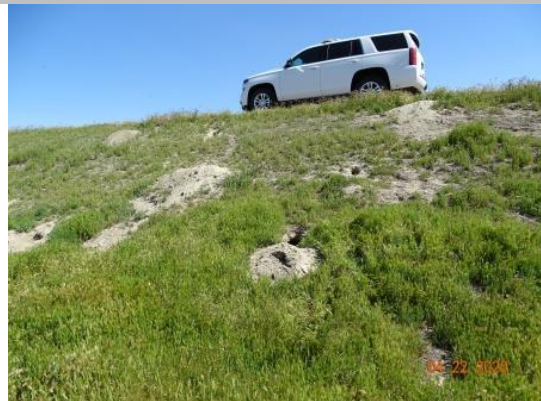
Photo 1 of 1 : FA_2022_NA0010_124_114_20220822_00036.jpg

LM Start	21.39	Rating **	M	Issue No.	114
LM End	21.39	Issue Type +	Ma	Location *	LS
Category	Earthen Levee			GPS Latitude/Longitude	
				Start	End
Item	Animal Control			37.106397 °	37.106397 °
				-120.556727 °	-120.556727 °
DWR ID	DWR_NA0010_06_f _ 2019_114				
Comment Code					
A3 : No rodents visible, but rodent burrows visible; need to backfill and compact or grout burrows.					
Inspector Comment

View of rodent burrows on the landside slope. (Spring 2020)

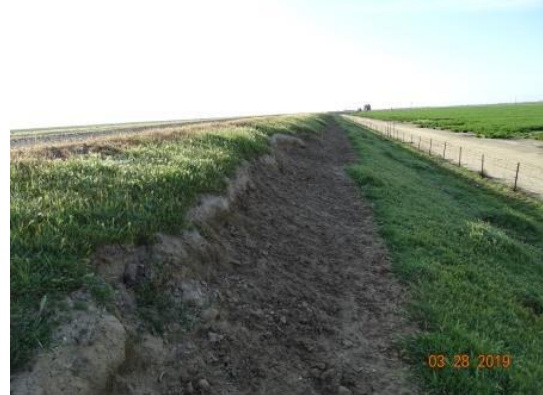
Photo 1 of 1 : FA_2022_NA0010_124_107_20220822_00032.jpg

LM Start	21.71	Rating **	M	Issue No.	107
LM End	21.78	Issue Type +	Ma	Location *	LS
Category	Earthen Levee			GPS Latitude/Longitude	
				Start	End
Item	Erosion / Livestock			37.102844 °	37.102002 °
				-120.553160 °	-120.552314 °
DWR ID	DWR_NA0010_06_f_2018_107				
Comment Code					
E4 : Repair the levee slope damaged by livestock and prevent large animal access.					
Inspector Comment					
Erosion into levee prism due to livestock activities.

View of erosion in landside levee prism. (Spring 2019)

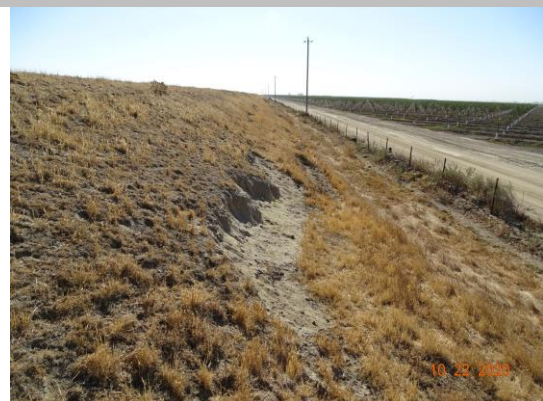
Photo 1 of 1 : FA_2022_NA0010_124_86_20220822_00021.jpg

LM Start	22.09	Rating **	M	Issue No.	86
LM End	22.46	Issue Type +	Ma	Location *	LS
Category	Earthen Levee			GPS Latitude/Longitude	
				Start	End
Item	Erosion / Livestock			37.098524 °	37.094479 °
				-120.548781 °	-120.544435 °
DWR ID	DWR_NA0010_06_f_2017_86				
Comment Code					
E4 : Repair the levee slope damaged by livestock and prevent large animal access.					
Inspector Comment					
Erosion greater than 3 inches on landside slope caused by livestock.

Looking upstream along the landside slope. (Fall 2020)

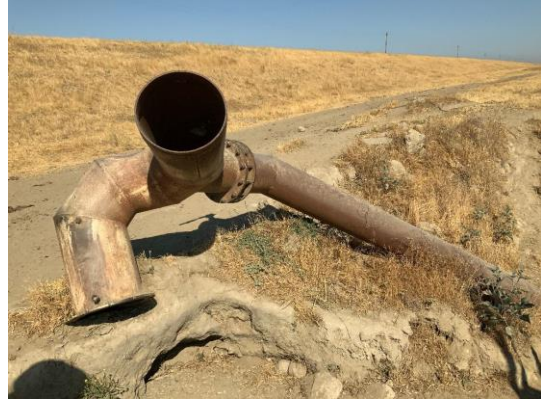
Photo 1 of 1 : UCIP_FA_2022_71142_101603.jpg

Comment Code						
Inspector Comment						
DS_ID:19812 FS_ID:71142 EP_NO: 12657 Repair Type: Non-Urgent EVAL Issue: 10, Unauthorized Modification or Non-Compliant Permit Crossing Status: Found UCIP Comments: 07/12/2021 The record has been upgraded from No Action Needed to Non-Urgent. One of the attached pipes on WS appears to have been removed and is not attached. Unable to access LS riser due to barbed wire. The UCIP inspection was completed with GEI staff, P. Espinoza. (H. Dunn – GEI) FIELD_STRUCT_DESC: 16-inch coated steel irrigation discharge pipe through the levee, 4.0 feet below the crown. Cutoff wall around the pipe at the center of the levee. Portable pump on the waterside (WS). Concrete standpipe on the landside (LS) slope with a timber walkway access ramp. Siphon breaker on the LS shoulder. Intake trench from the channel to the WS toe. (Diversion pump and discharge pipe authorized under Permit No. 12657, 1979 - Laurie H. Hall, Mary H. Hicks, and William E. Hammonds). [Additional Reference(s): DWR Levee Log, 2002, (HLM 22.82)]. FS Date: 7/12/2021

WS view: Portion of pipe not attached and discarded.

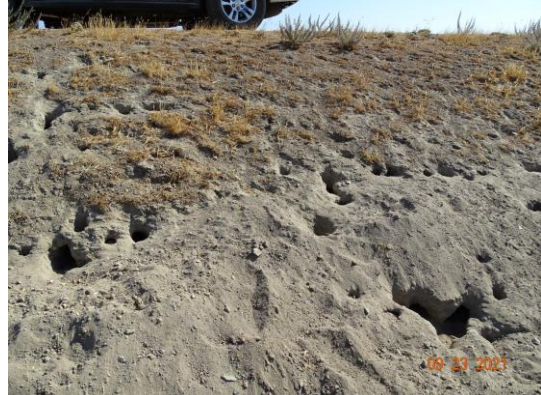
Photo 1 of 1 : FA_2022_NA0010_124_110_20220822_00034.jpg

LM Start	23.11	Rating **	M	Issue No.	110
LM End	23.11	Issue Type +	Ma	Location *	LS
Category	Earthen Levee			GPS Latitude/Longitude	
				Start	End
Item	Animal Control			37.087312 °	37.087312 °
				-120.536662 °	-120.536662 °
DWR ID	DWR_NA0010_06_f_2021_110				
Comment Code					
A3 : No rodents visible, but rodent burrows visible; need to backfill and compact or grout burrows.					
Inspector Comment

View of rodent burrows on the landside slope. (Fall 2021)
